Pre Building Condition Survey Report

Name and Address of Structure :	Choti Chopar to Badi Chopar (UP Line)
---------------------------------	---------------------------------------

Name of the Project	Contract JMRC-UG1B “Design and Construction of Tunnel between Chandpole and Badi Chouper and reverse line by Shield TBM, Underground Metro Stations at Choti Chouper and Badi Chouper by Cut and Cover Methods on East West Corridor of Jaipur Metro Rail Corporation Limited .”	
Owner :

Shoping Complex - Shop No. 169-188
Tripolia Bazar
Jaipur
Unique ID: CC BC UP 0001

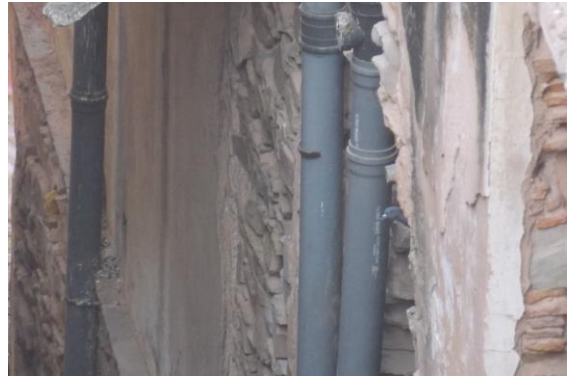
Photo 94
Damaged Portion of Outer wall of Building L/S of Third Floor

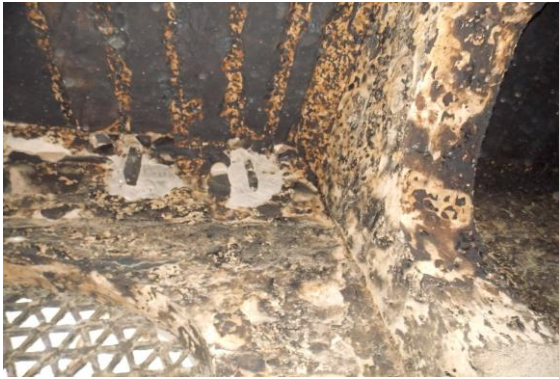
Photo 97
Damaged Portion on Roof, All Wall & Floor of Hall No. 1 of Ground Floor

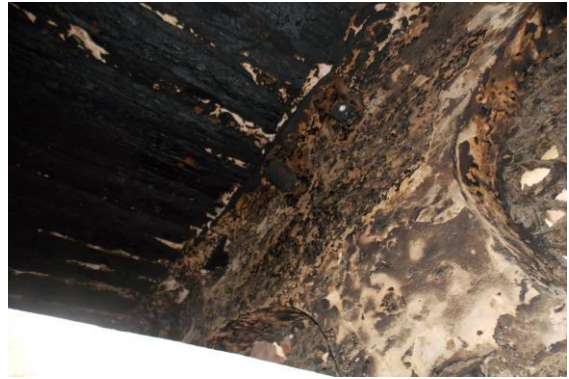
Photo 98

Damaged Portion on Roof, All Wall & Floor of Hall No. 1 of Ground Floor

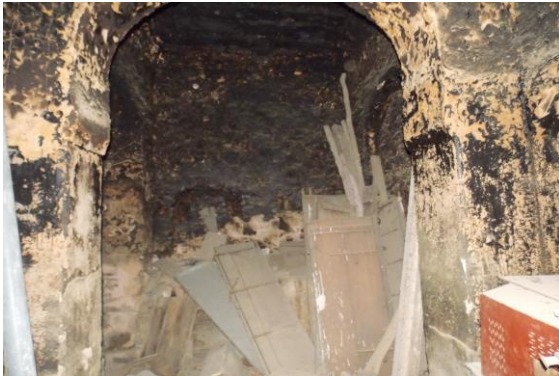
Photo 99

Damaged Portion on Roof, All Wall & Floor of Hall No. 1 of Ground Floor

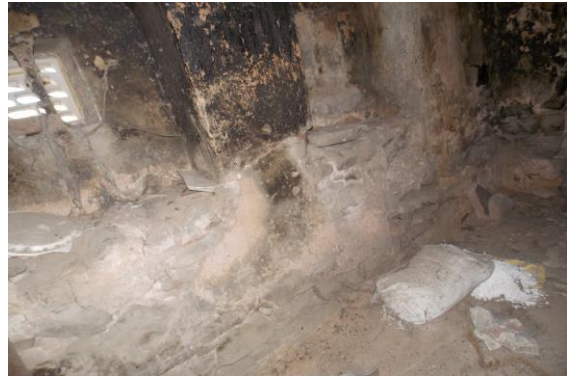
Photo 100

Damaged Portion on Roof, All Wall & Floor of Hall No. 1 of Ground Floor

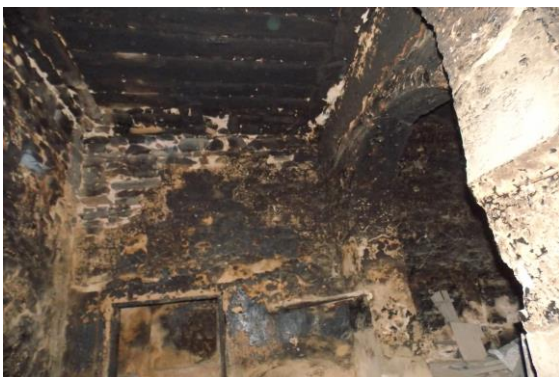
Photo 101

Damaged Portion on Roof, All Wall & Floor of Hall No. 1 of Ground Floor

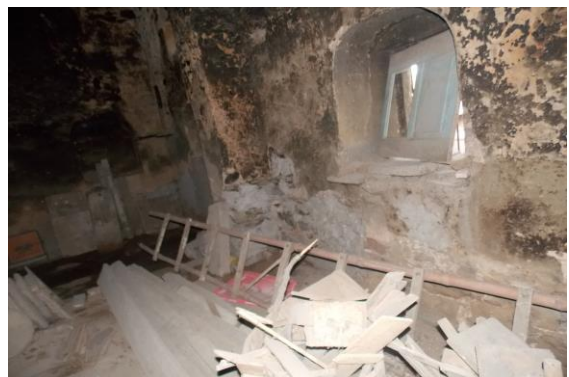
Photo 102

Damaged Portion on Roof, All Wall & Floor of Hall No. 1 of Ground Floor

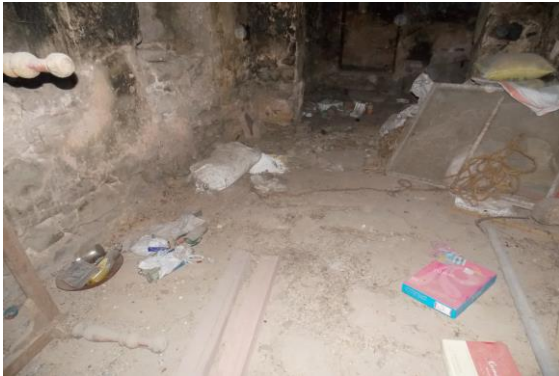
Photo 103

Damaged Portion on Roof, All Wall & Floor of Hall No. 1 of Ground Floor

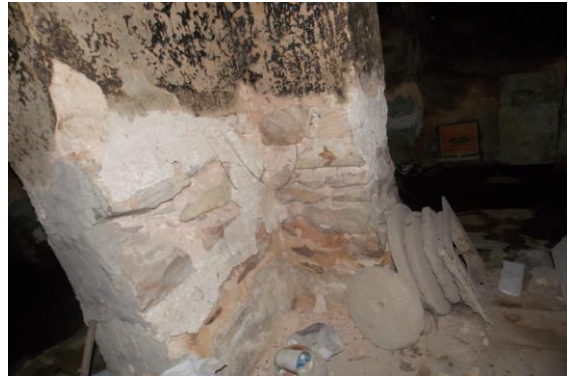
Photo 104

Damaged Portion on Roof, All Wall & Floor of Hall No. 1 of Ground Floor

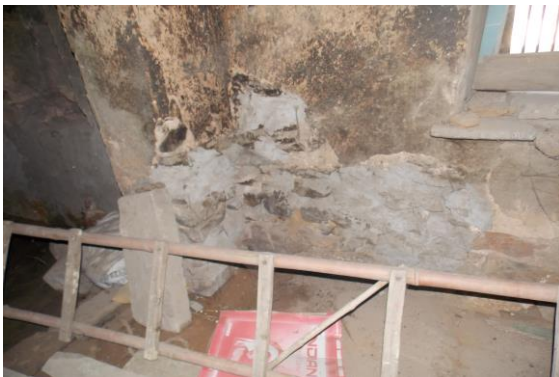
Photo 105

Damaged Portion on Roof, All Wall & Floor of Hall No. 1 of Ground Floor

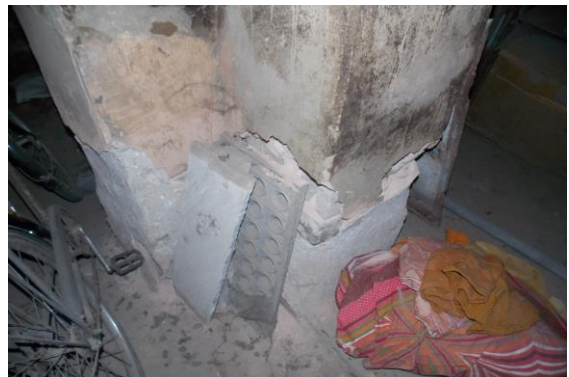
Photo 106

Damaged Portion on Roof, All Wall & Floor of Hall No. 1 of Ground Floor

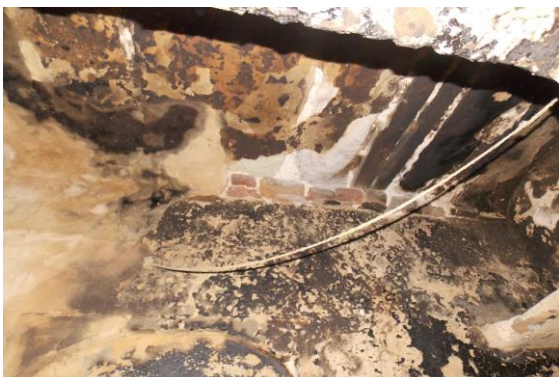
Photo 107

Damaged Portion on Roof, All Wall & Floor of Hall No. 1 of Ground Floor

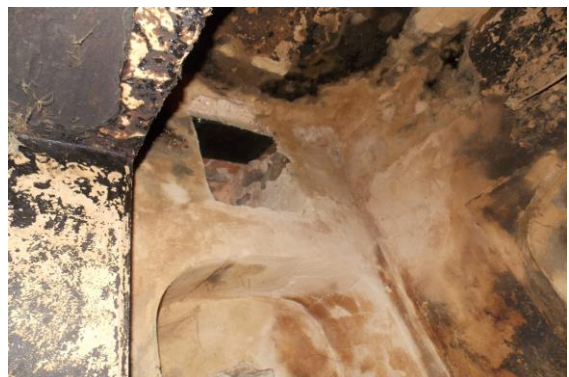
Photo 108

Damaged Portion of Room No. 1 of Ground Floor

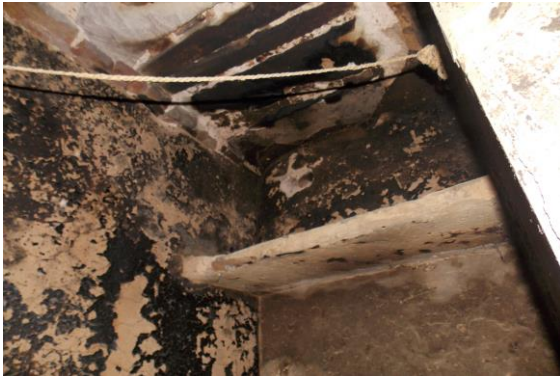
Photo 109

Damaged Portion of Room No. 1 of Ground Floor

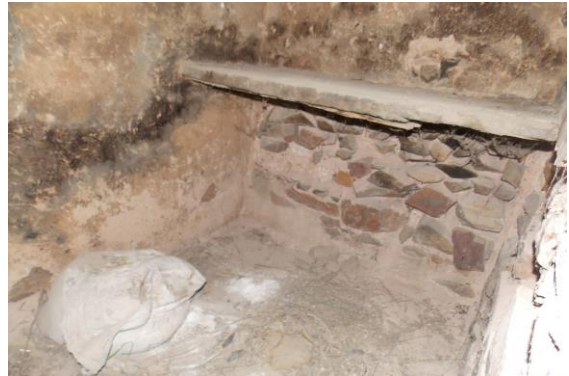
Photo 110
Damaged Portion of Room No. 1 of Ground Floor

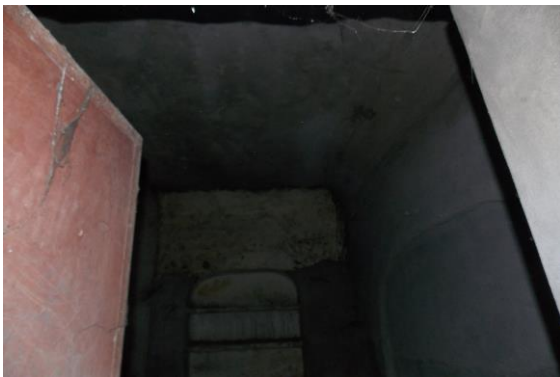
Photo 111
Damaged Portion of Room No. 1 of Ground Floor

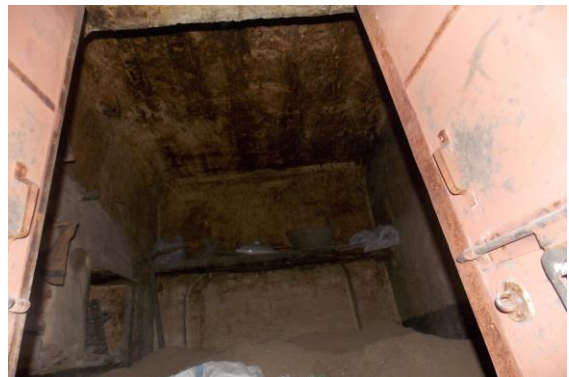
Photo 112
Damaged Portion on Roof & All Wall of Room No. 3 of Ground Floor

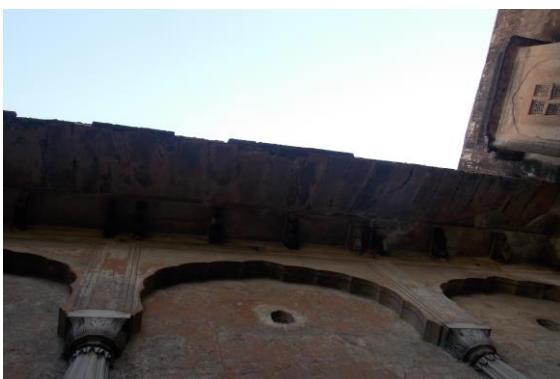
Photo 113
Dampness/Seepage of Room No. 4 of Ground Floor

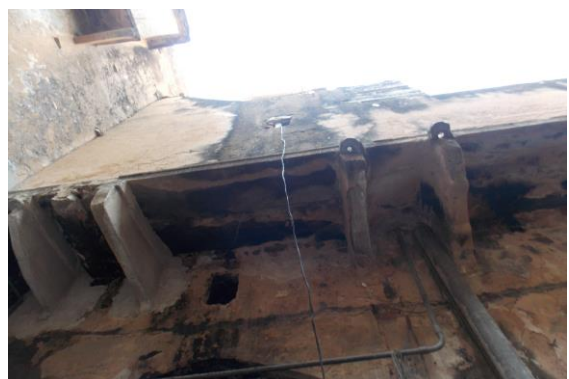
Photo 114
Damaged Portion on Sunshade of Open Area 1 of Second Floor

Photo 115
Damaged Portion on Sunshade of Open Area 1 of First Floor

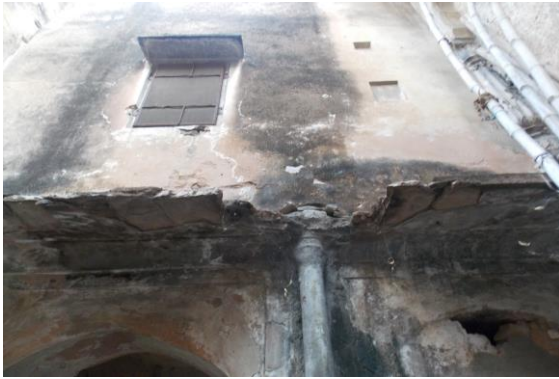
Photo 116

Damaged Portion on Sunshade of Open Area 1 of Ground Floor

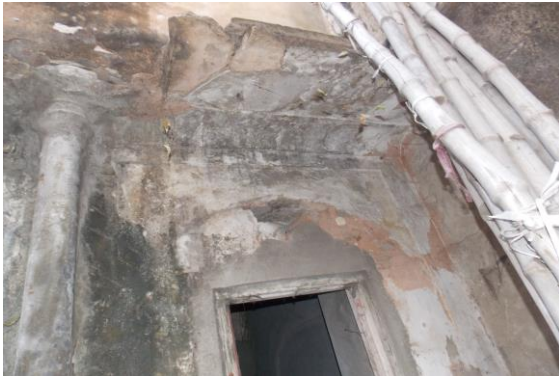
Photo 118

Damaged Portion on Wall No. 3 of Open Area 1 of Ground Floor

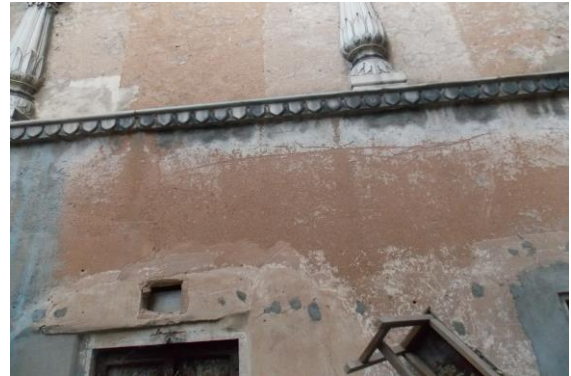
Photo 119

Peeling of Plaster on Wall No. 1 of Open Area 1 of Ground Floor

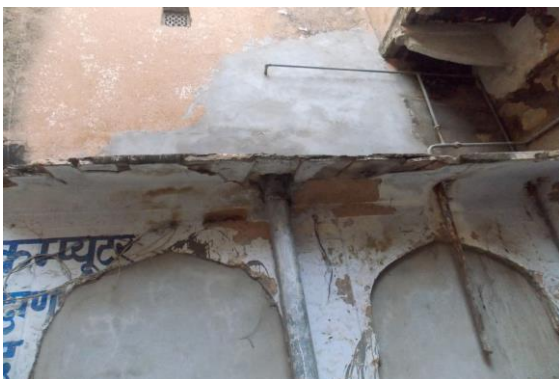
Photo 120

Peeling of Plaster on Wall No. 4 of Open Area 1 of Ground Floor

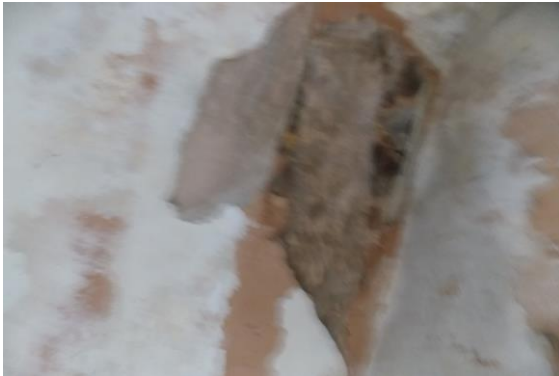
Photo 122
Damaged Portion on Roof of Passage 1 of Ground Floor

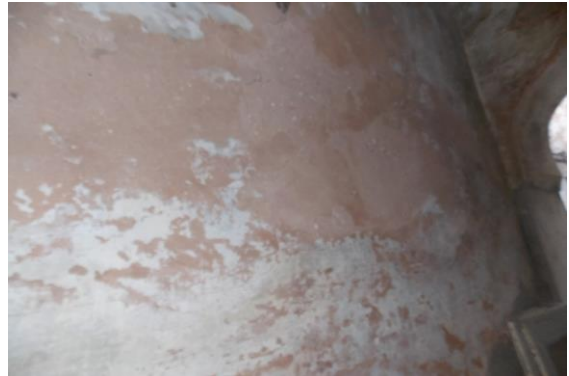
Photo 123
Peeling of Plaster on Wall No. 1 of Passage 1 of Ground Floor

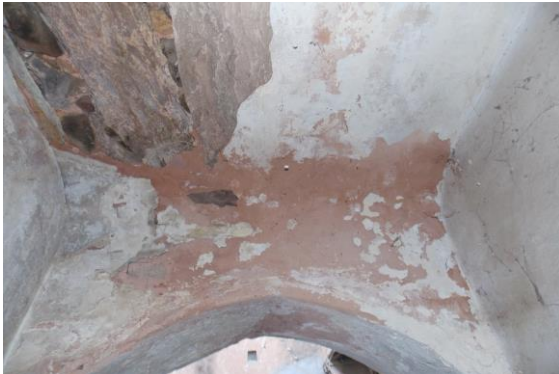
Photo 124
Peeling of Plaster on Wall No. 4 of Passage 1 of Ground Floor

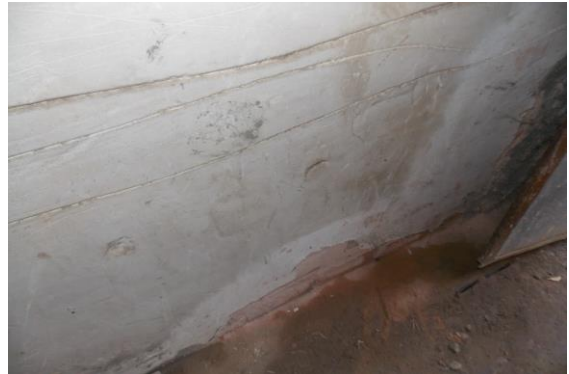
Photo 125
Peeling of Plaster on Wall No. 2 of Passage 1 of Ground Floor

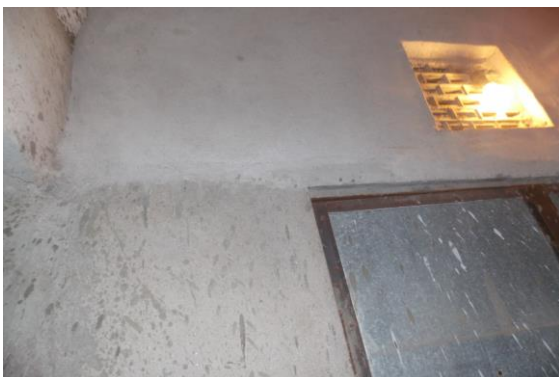
Photo 126
Damaged Portion on Wall No. 1 of Passage 2 of Ground Floor

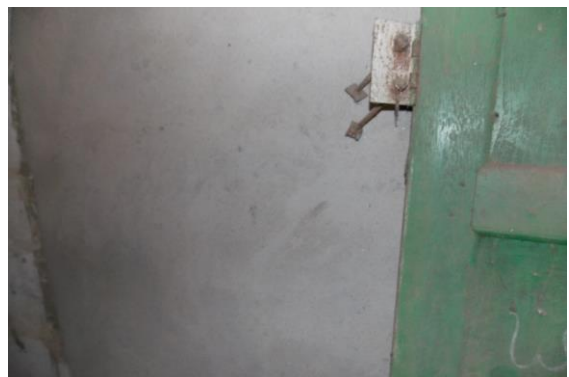
Photo 127
Damaged Portion on Wall No. 2 of Passage 2 of Ground Floor

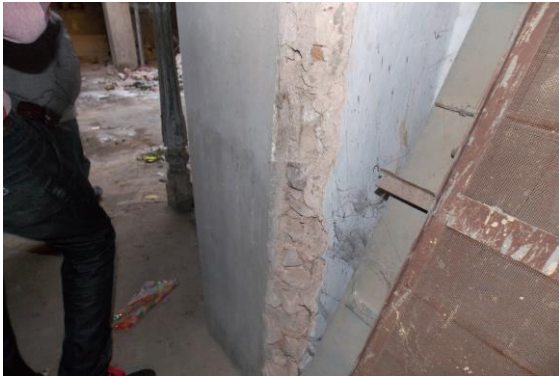
Photo 128
Damaged Portion on Wall No. 3 of Passage 2 of Ground Floor

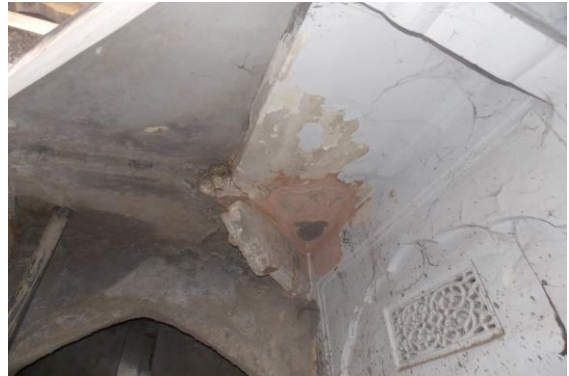
Photo 129
Damaged Portion on Sunshade of Open Area 2 of Ground Floor

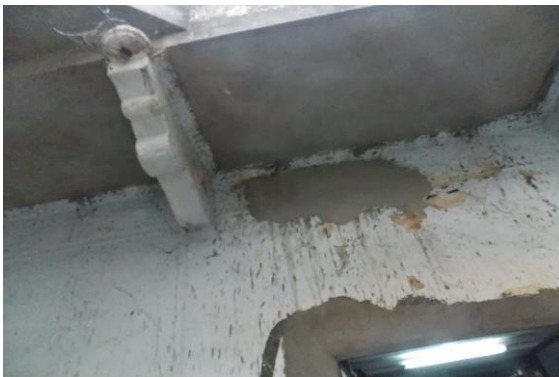
Photo 130
Damaged Portion on Sunshade of Open Area 2 of Ground Floor

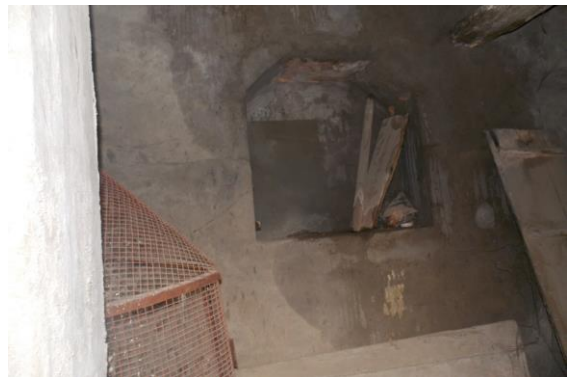
Photo 131
Damaged Portion on Wall No. 4 of Open Area 2 of Ground Floor

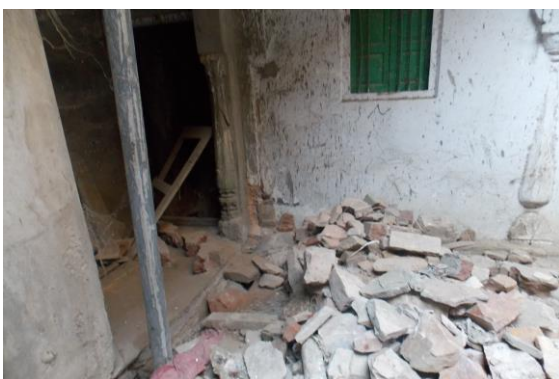
Photo 132
Peeling of Plaster on Wall No. 2 of Open Area 2 of Ground Floor

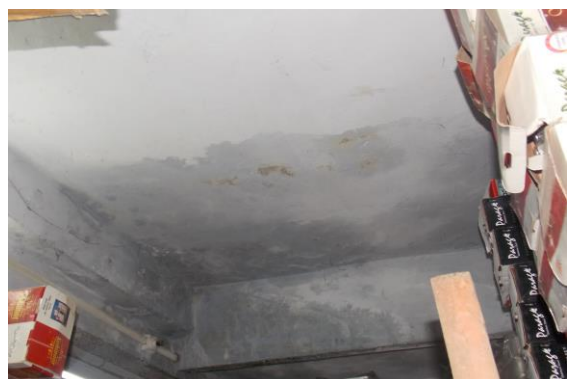
Photo 133
Dampness/Seepage on Roof of Room No. 9 of Ground Floor

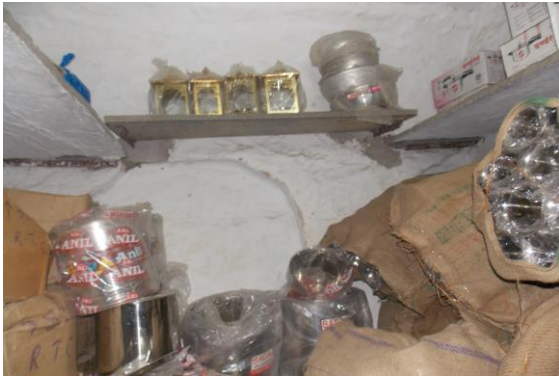
Photo 134

Peeling of Plaster on Wall No. 4 of Room No. 10 of Ground Floor

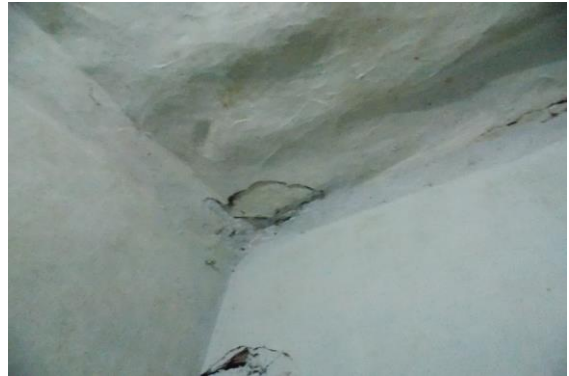
Photo 135

Peeling of Plaster on Roof of Room No. 11 of Ground Floor

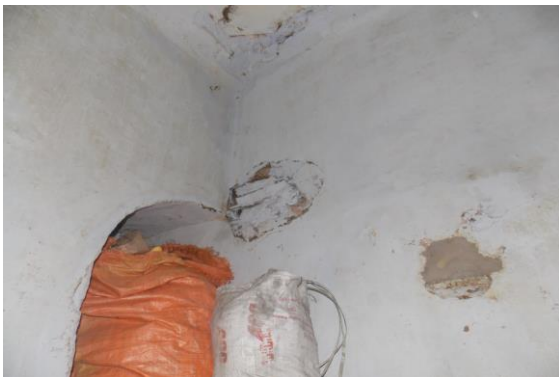
Photo 136

Peeling of Plaster on Wall No. 1 of Room No. 11 of Ground Floor

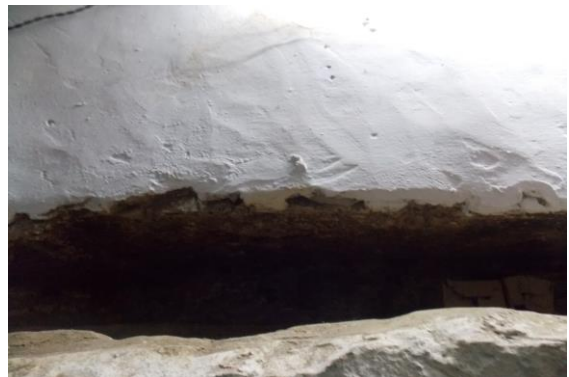
Photo 137

Damaged Portion on Wall No. 3 of Room No. 12 of Ground Floor

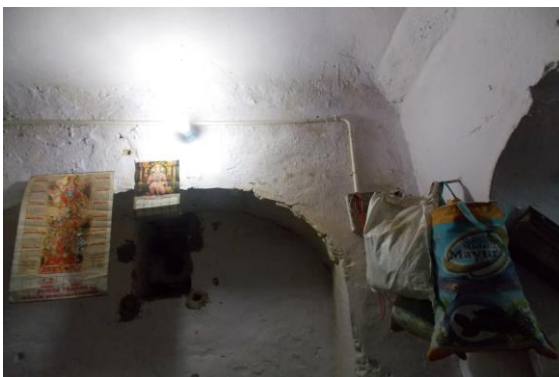
Photo 138

Dampness/Seepage on Wall No. 4 of Room No. 16 of Ground Floor

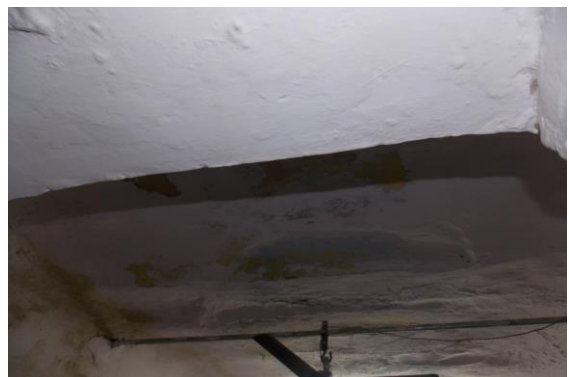
Photo 139

Dampness/Seepage on Roof of Room No. 16 of Ground Floor

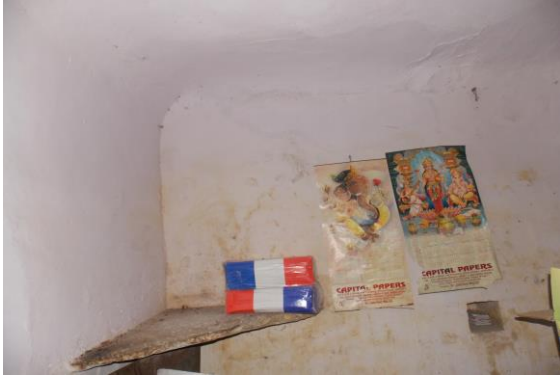
Photo 140

Dampness/Seepage on Wall No. 4 of Room No. 15 of Ground Floor

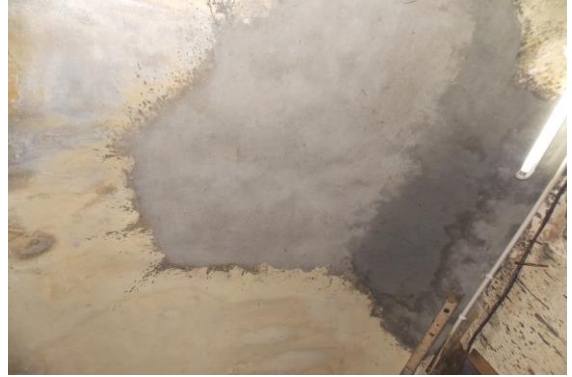
Photo 141

Damaged Portion on Roof of Room No. 14 of Ground Floor

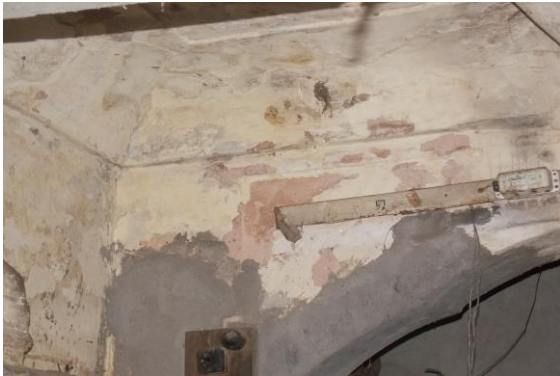
Photo 142

Peeling of Plaster on Wall No. 2 of Room No. 14 of Ground Floor

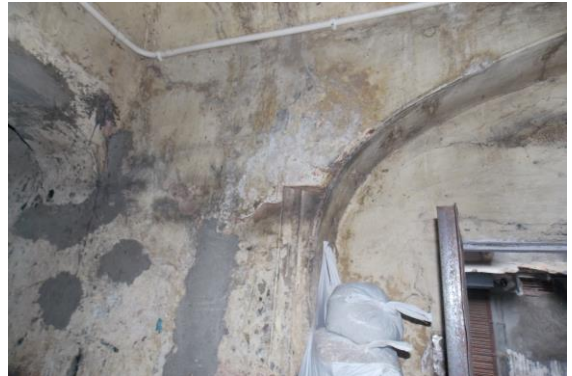
Photo 143

Peeling of Plaster on Wall No. 3 of Room No. 14 of Ground Floor

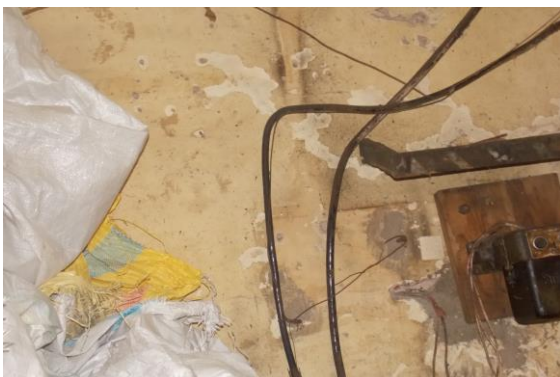
Photo 144

Peeling of Plaster on Wall No. 1 of Room No. 14 of Ground Floor

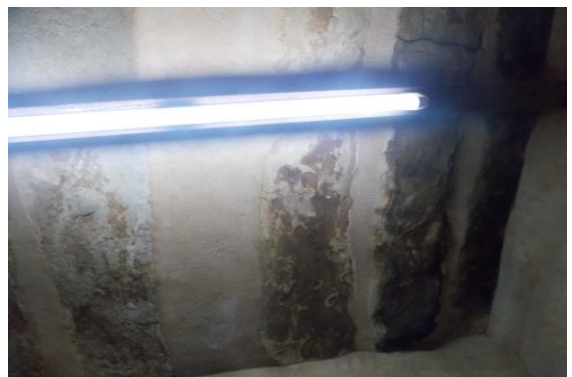
Photo 145

Dampness/Seepage on All Wall of Room No. 17 of Ground Floor

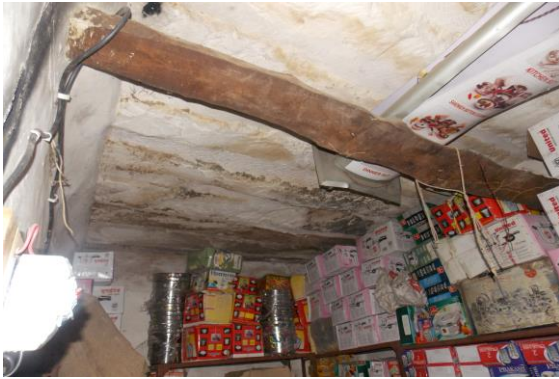
Photo 146
Damaged Portion on Roof of Room No. 18 of Ground Floor

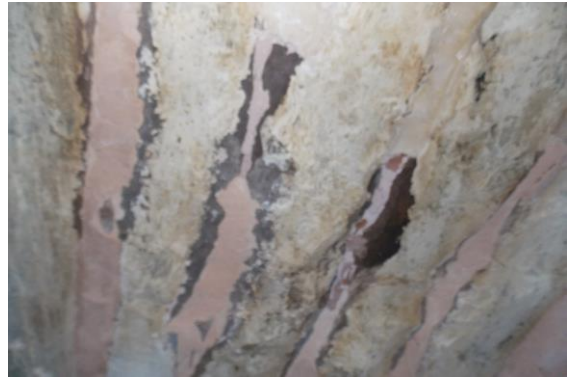
Photo 147
Dampness/Seepage on Roof of Room No. 19 of Ground Floor

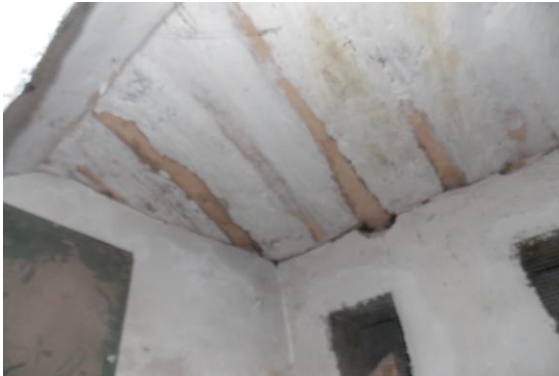
Photo 148
Dampness/Seepage on Roof of Room No. 20 of Ground Floor

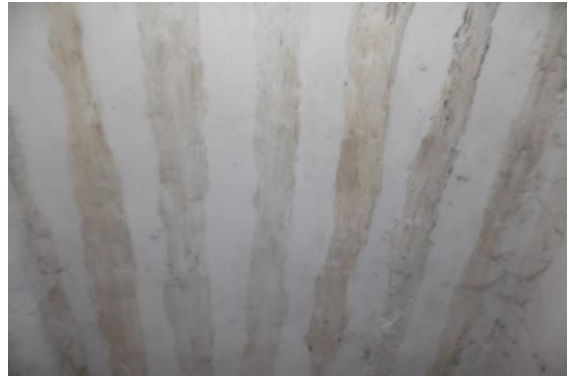
Photo 149
Dampness/Seepage on Roof of Room No. 21 of Ground Floor

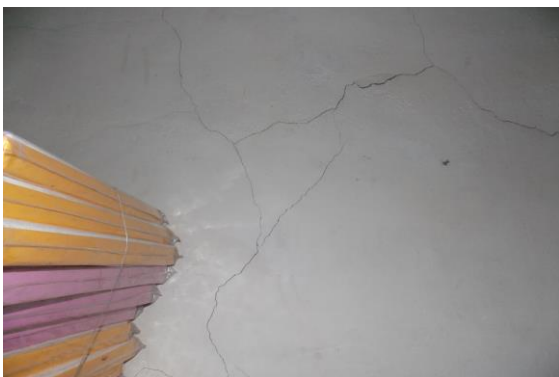
Photo 150
Plaster Crack on Wall No. 1 of Room No. 21 of Ground Floor

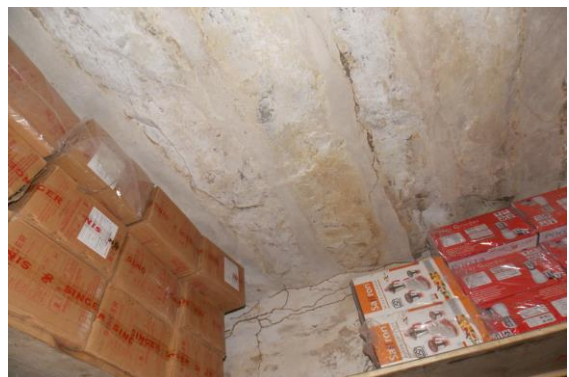
Photo 151
Damaged Portion on Roof of Room No. 22 of Ground Floor

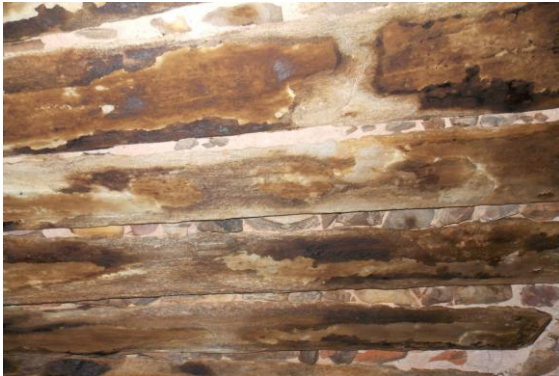
Photo 152

Damaged Portion on All Wall & Roof of Room No. 23 of Ground Floor

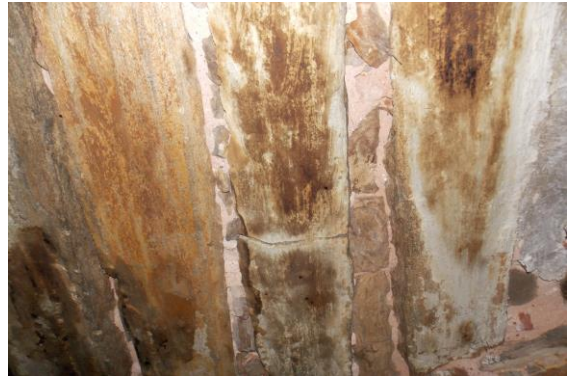
Photo 153

Damaged Portion on All Wall & Roof of Room No. 23 of Ground Floor

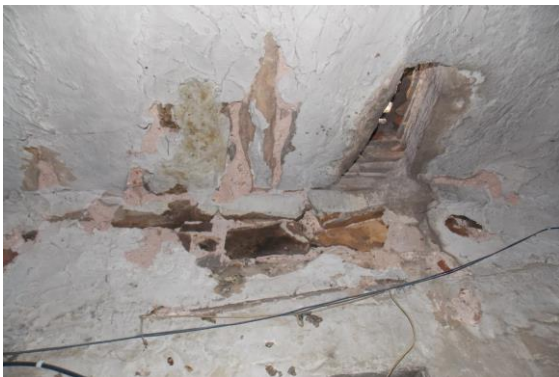
Photo 154

Damaged Portion on All Wall & Roof of Room No. 23 of Ground Floor

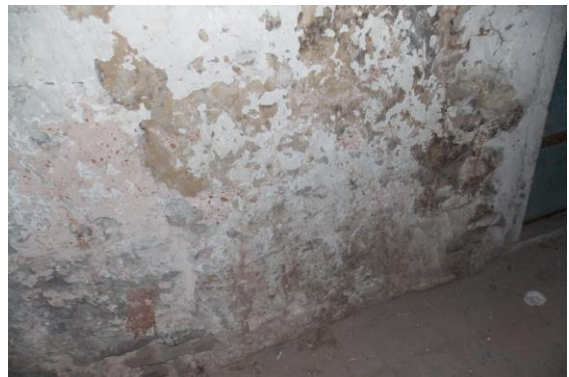
Photo 155

Damaged Portion on All Wall & Roof of Room No. 23 of Ground Floor

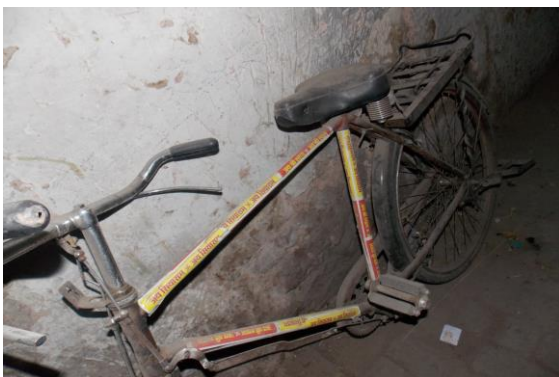
Photo 156

Damaged Portion on All Wall & Roof of Room No. 23 of Ground Floor

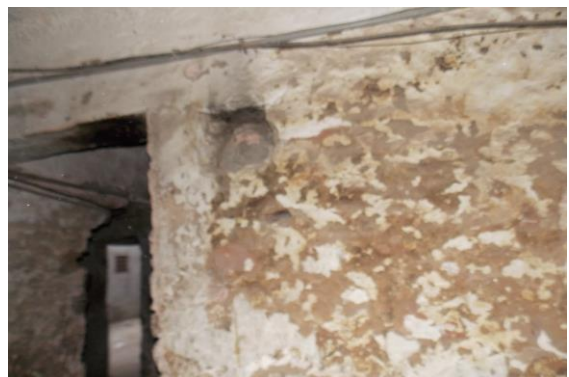
Photo 157

Damaged Portion on All Wall & Roof of Room No. 23 of Ground Floor

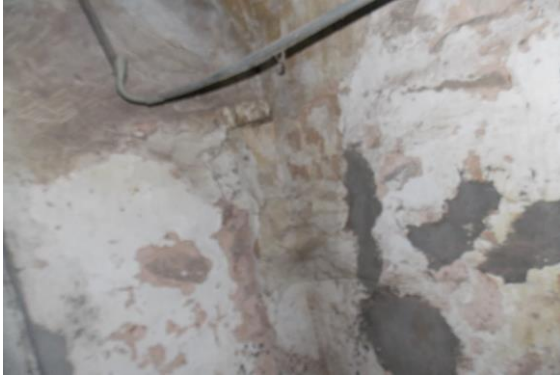
Photo 158

Damaged Portion on All Wall & Roof of Room No. 23 of Ground Floor

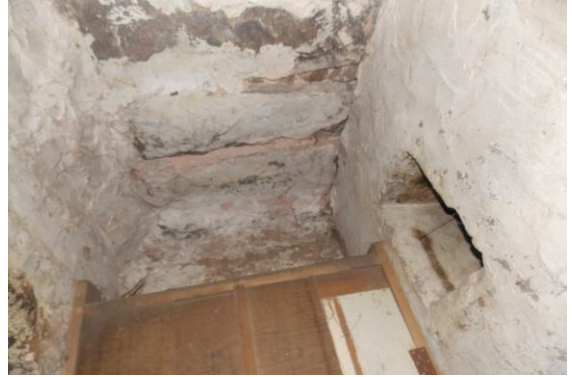
Photo 159

Damaged Portion on All Wall & Roof of Room No. 23 of Ground Floor

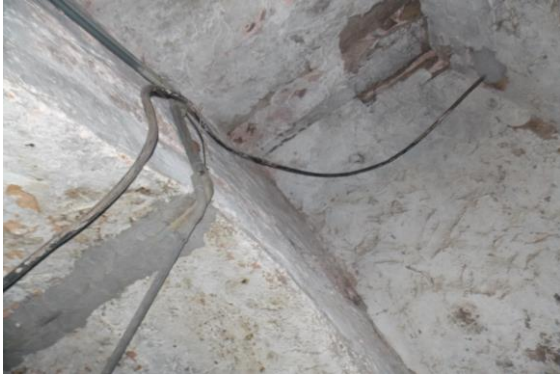
Photo 160

Damaged Portion on All Wall & Roof of Room No. 23 of Ground Floor

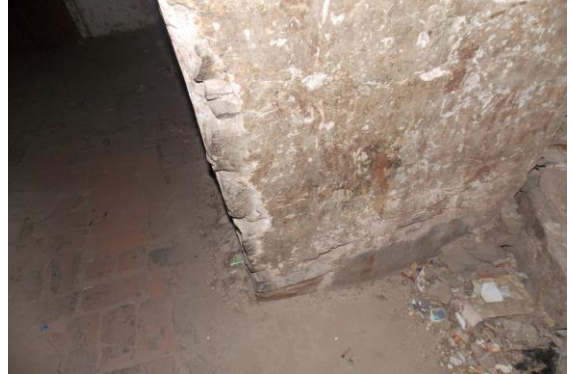
Photo 161

Damaged Portion on All Wall & Roof of Room No. 23 of Ground Floor

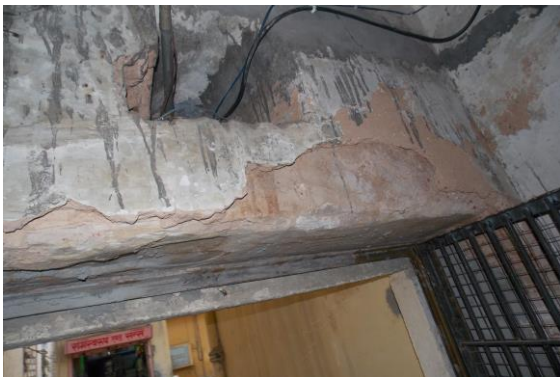
Photo 162

Damaged Portion on All Wall & Roof of Room No. 23 of Ground Floor

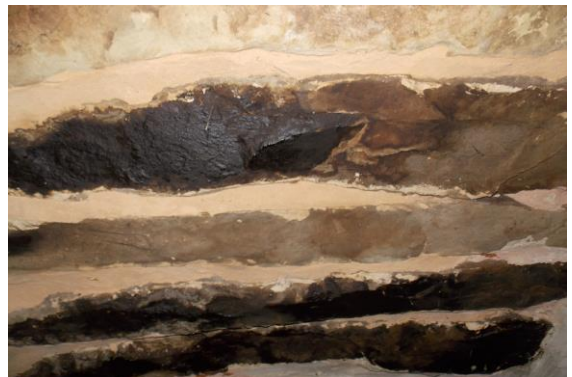
Photo 163

Damaged Portion on Roof of Room No. 24 of Ground Floor

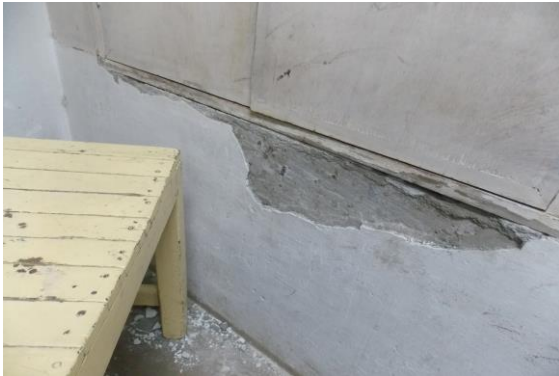
Photo 164

Peeling of Plaster on Wall No. 1 of Room No. 26 of Ground Floor

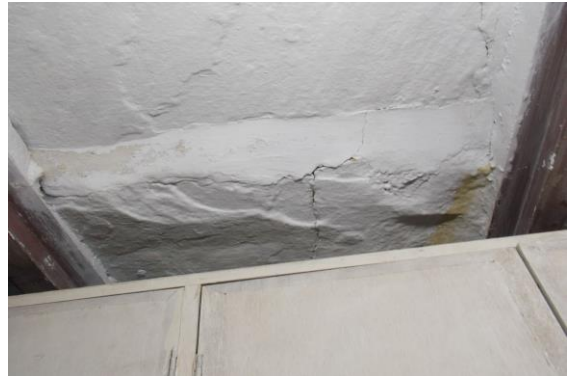
Photo 165

Peeling of Plaster on Roof of Room No. 26 of Ground Floor

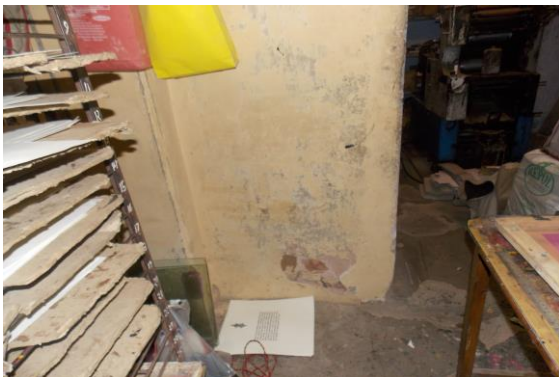
Photo 166

Peeling of Plaster on Wall No. 1 of Room No. 28 of Ground Floor

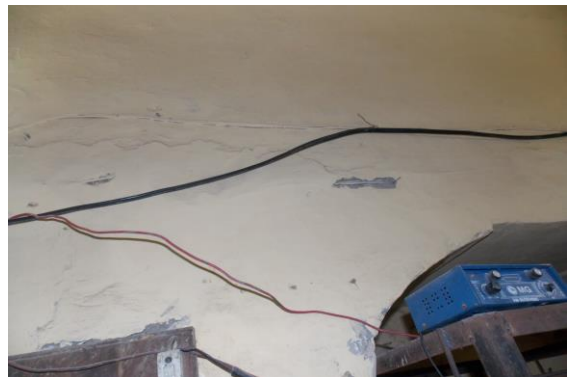
Photo 167

Peeling of Plaster on Wall No. 3 of Room No. 28 of Ground Floor

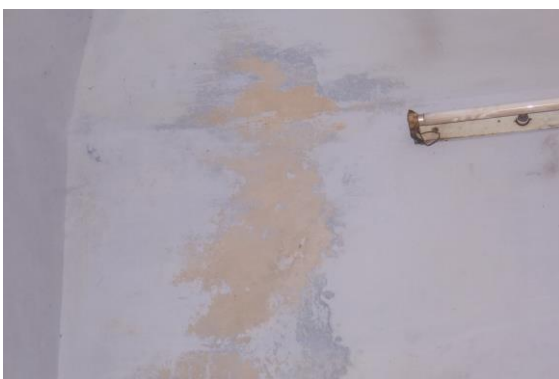
Photo 168

Dampness/Seepage on Wall No. 4 of Room No. 29 of Ground Floor

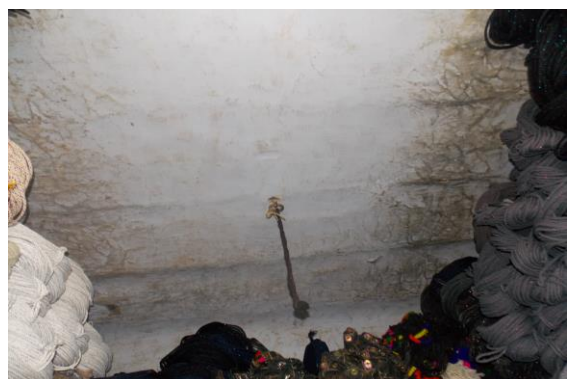
Photo 169

Dampness/Seepage on Roof of Room No. 31 of Ground Floor

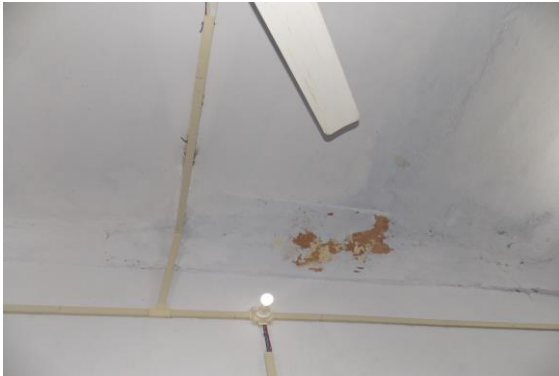
Photo 170

Peeling of Plaster on Roof of Room No. 33 of Ground Floor

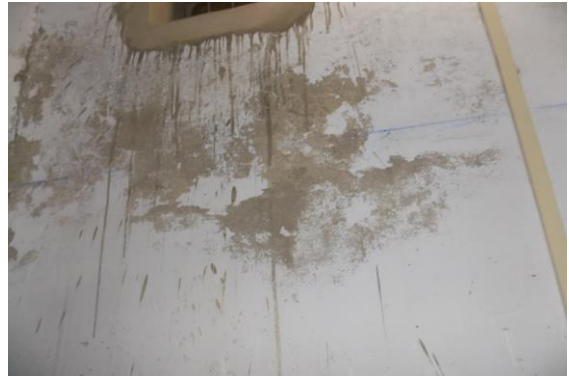
Photo 171

Peeling of Plaster on Wall No. 1 of Room No. 33 of Ground Floor

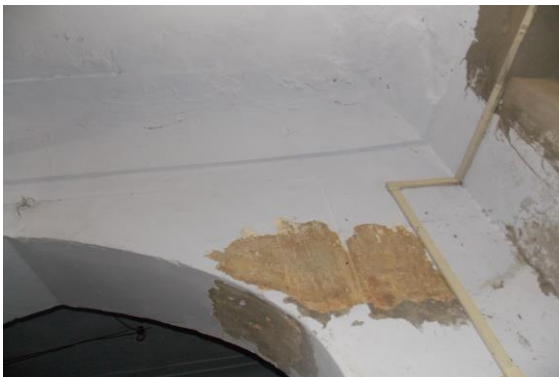
Photo 172

Peeling of Plaster on Wall No. 3 of Room No. 33 of Ground Floor

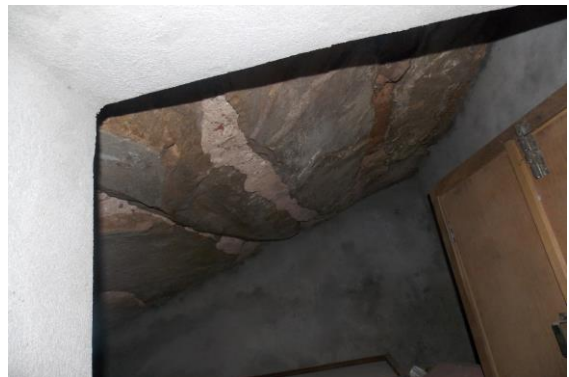
Photo 173

Damaged Portion on Roof of Store 3 of Ground Floor

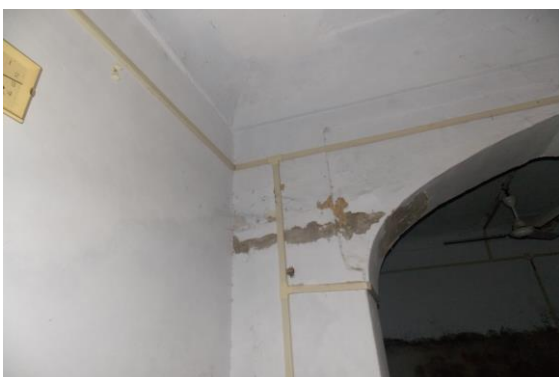
Photo 174

Peeling of Plaster on Wall No. 4 of Room No. 33 of Ground Floor

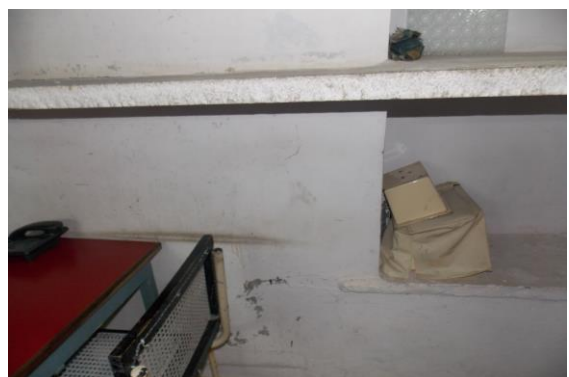
Photo 175

Peeling of Plaster on Wall No. 4 of Room No. 36 of Ground Floor

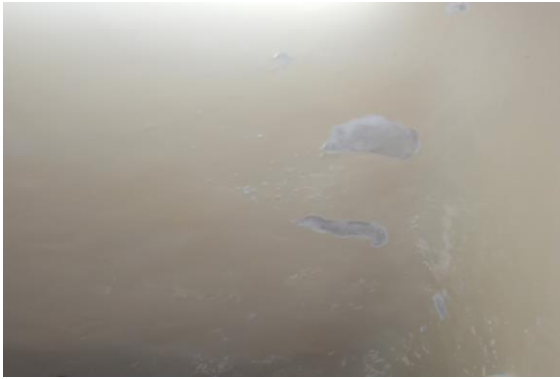
Photo 176
Peeling of Plaster on Roof of Room No. 37 of Ground Floor

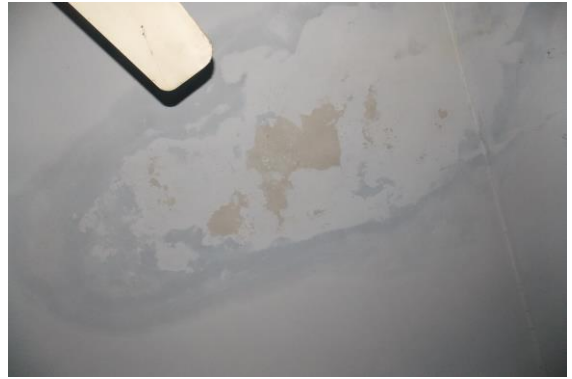
Photo 177
Peeling of Plaster on Roof of Room No. 41 of Ground Floor

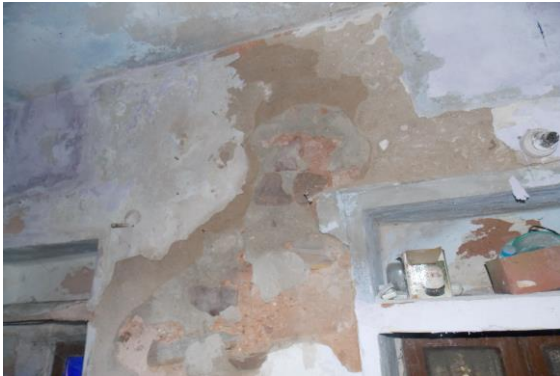
Photo 178
Peeling of Plaster on Wall No. 4 of Room No. 41 of Ground Floor

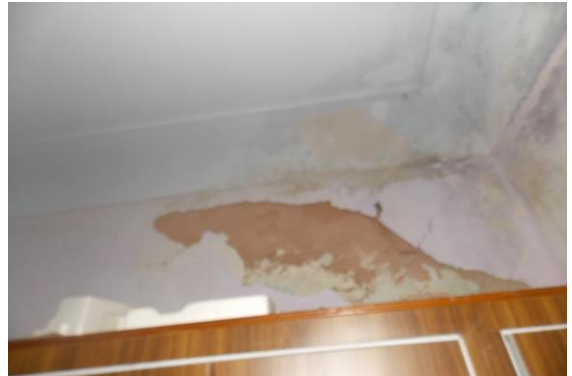
Photo 179
Peeling of Plaster on Wall No. 1 of Room No. 41 of Ground Floor

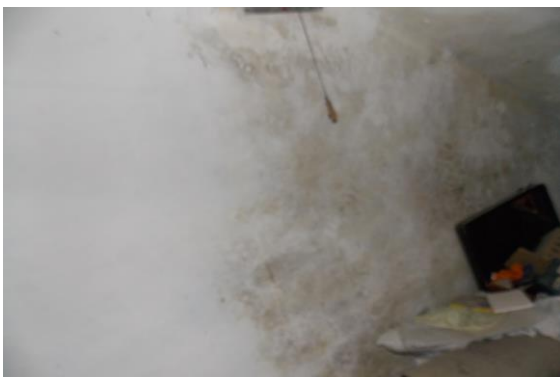
Photo 180
Dampness/Seepage on Wall No. 4 of Store 3 of Ground Floor

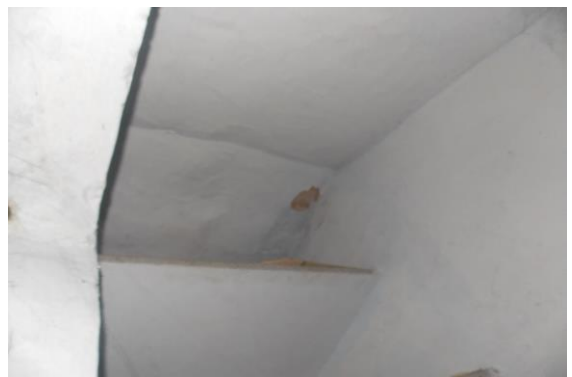
Photo 181
Peeling of Plaster on Roof of Store 3 of Ground Floor

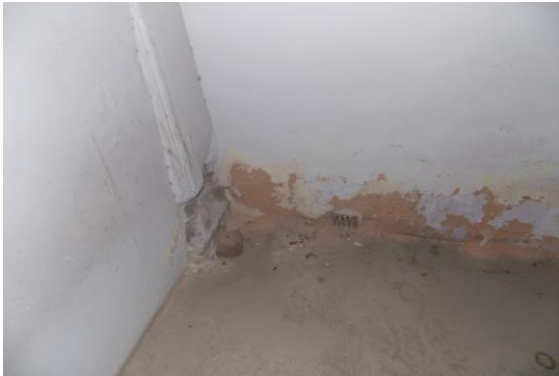
Photo 182

Peeling of Plaster on Wall No. 1 & 3 of Room No. 43 of Ground Floor

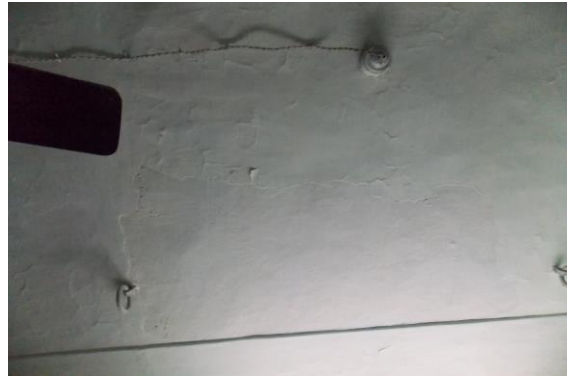
Photo 183

Peeling of Plaster on Roof of Room No. 42 of Ground Floor

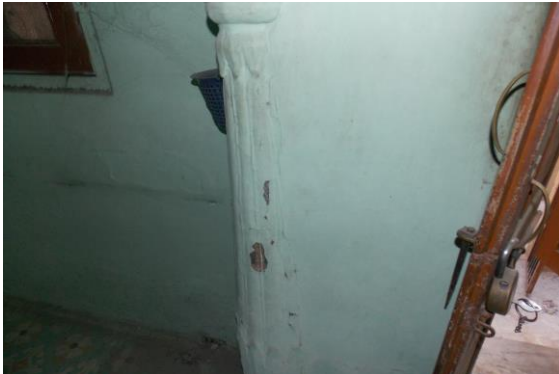
Photo 184

Peeling of Plaster on Wall No. 3 of Room No. 42 of Ground Floor

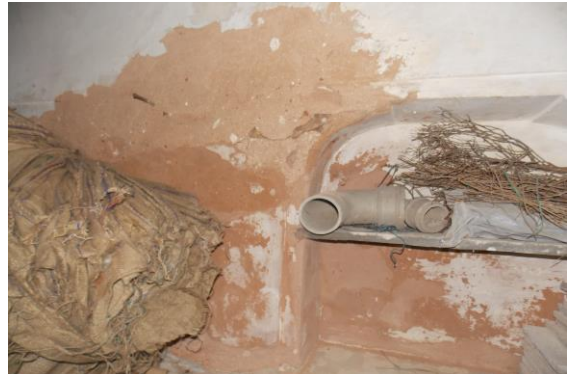
Photo 185

Peeling of Plaster on Wall No. 4 of Room No. 44 of Ground Floor

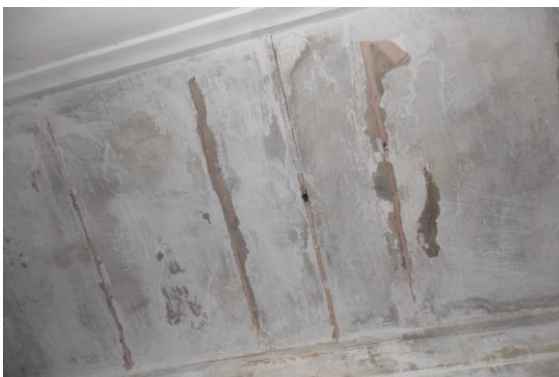
Photo 186

Peeling of Plaster on Roof of Room No. 44 of Ground Floor

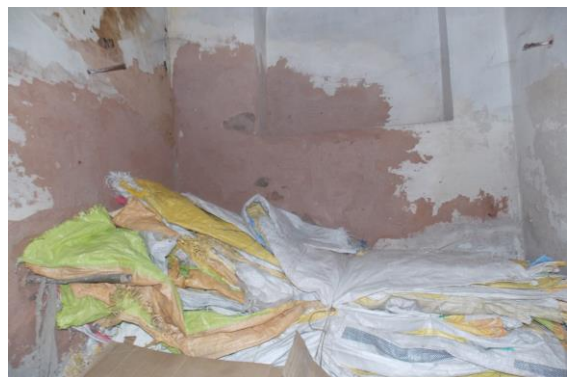
Photo 187

Peeling of Plaster on Wall No. 2 of Room No. 44 of Ground Floor

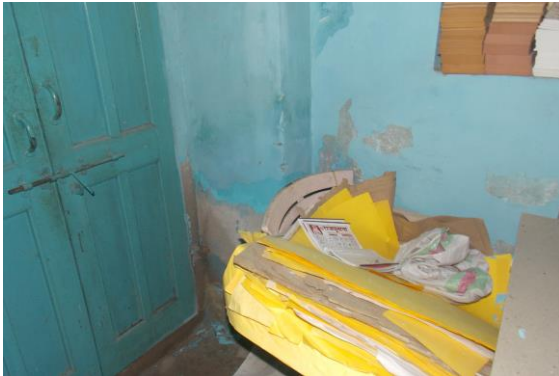
Photo 188

Peeling of Plaster on Wall No. 1 of Room No. 45 of Ground Floor

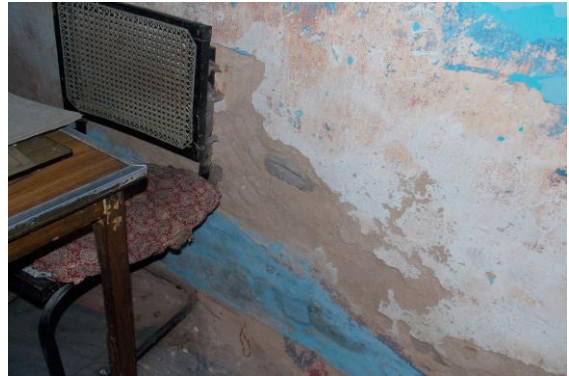
Photo 189

Peeling of Plaster on Wall No. 2 of Room No. 45 of Ground Floor

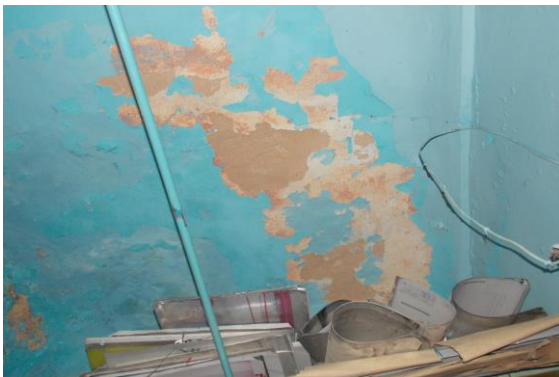
Photo 190

Peeling of Plaster on Roof of Room No. 45 of Ground Floor

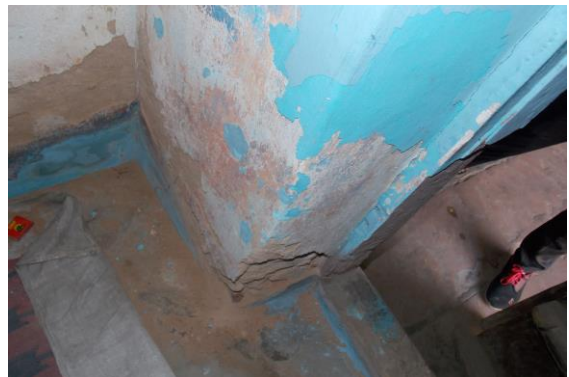
Photo 191

Peeling of Plaster on Wall No. 3 of Room No. 45 of Ground Floor

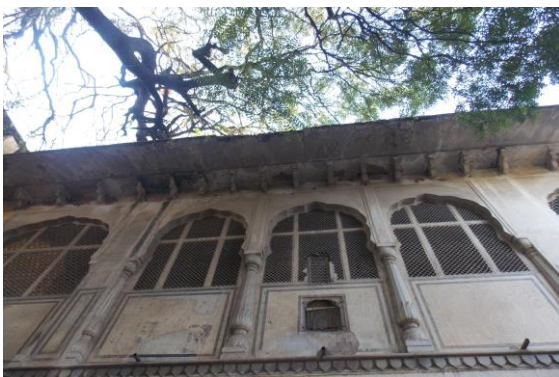
Photo 192

Damaged Portion on Sunshade of Open Area of Ground Floor

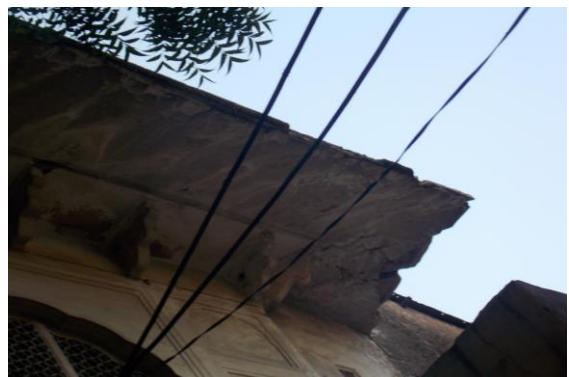
Photo 193

Damaged Portion on Sunshade of Open Area of Ground Floor

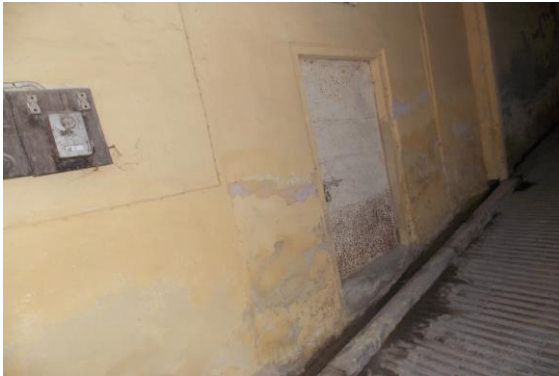
Photo 194
Peeling of Plaster on Wall No. 3 of Open Area of Ground Floor

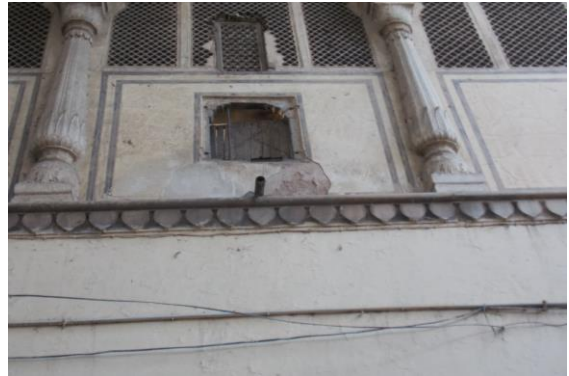
Photo 195
Peeling of Plaster on Wall No. 4 of Open Area of Ground Floor

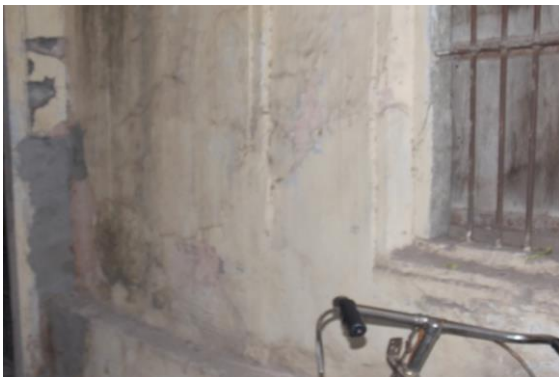
Photo 196
Peeling of Plaster on Wall No. 4 of Open Area of Ground Floor

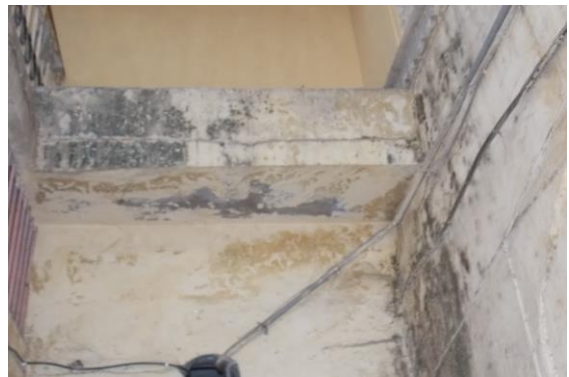
Photo 197
Dampness/Seepage on Wall No. 1 of Open Area of Ground Floor
