Pre Building Condition Survey Report

Name and Address of Structure :	Choti Chopar to Badi Chopar (UP Line)
---------------------------------	---------------------------------------

Name of the Project	Contract JMRC-UG1B “Design and Construction of Tunnel between Chandpole and Badi Chouper and reverse line by Shield TBM, Underground Metro Stations at Choti Chouper and Badi Chouper by Cut and Cover Methods on East West Corridor of Jaipur Metro Rail Corporation Limited .”	
Owner :

Shoping Complex - Shop No. 169-188
Tripolia Bazar
Jaipur
Unique ID: CC BC UP 0001

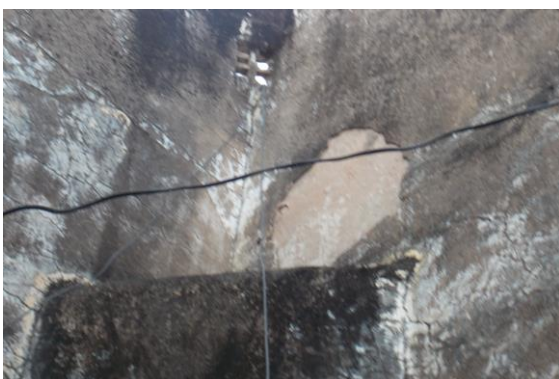
Photo 198
Peeling of Plaster on Wall No. 2 of Open Area of Ground Floor

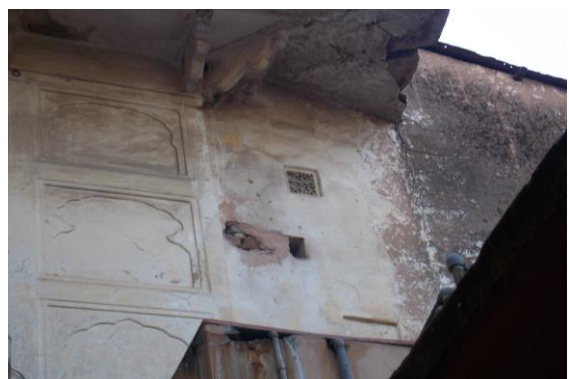
Photo 199
Damaged Portion on Wall No. 4 of Open Area of Ground Floor

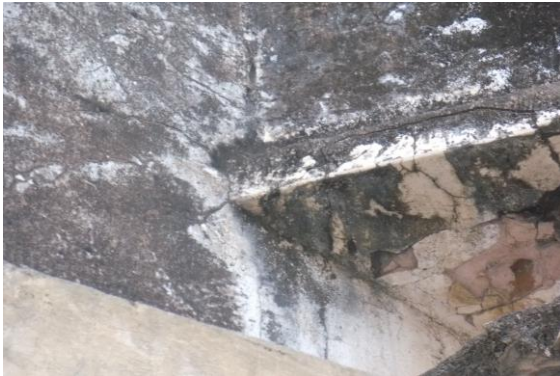
Photo 200
Damaged Portion on Wall No. 4 of Open Area of Ground Floor

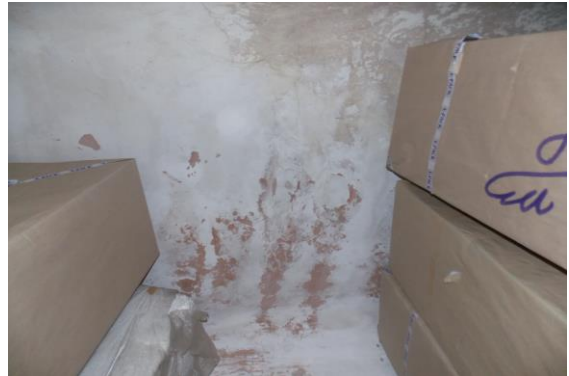
Photo 201
Dampness/Seepage on Roof of Room No. 47 of Ground Floor

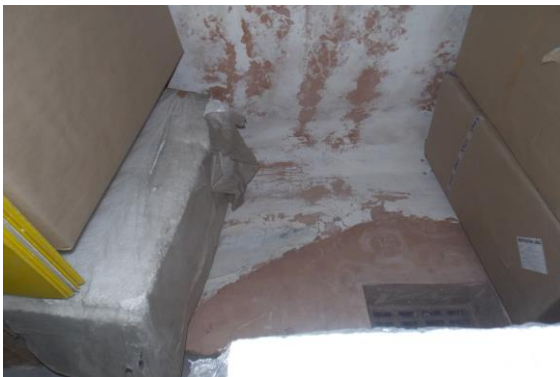
Photo 202
Dampness/Seepage on Wall No. 4 of Room No. 47 of Ground Floor

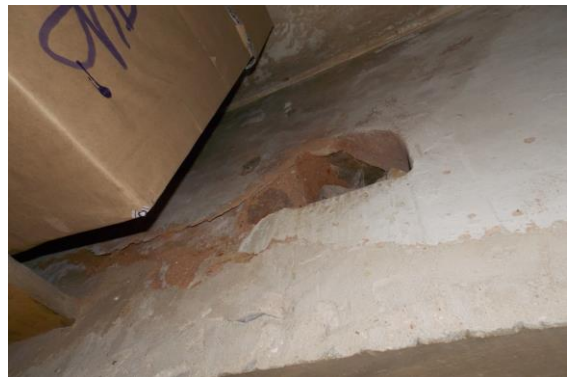
Photo 203
Damaged Portion on Wall No. 3 of Room No. 47 of Ground Floor

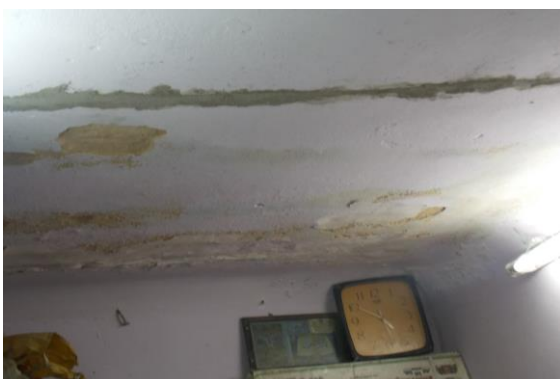
Photo 204
Dampness/Seepage on Roof of Room No. 1 of Ground Floor

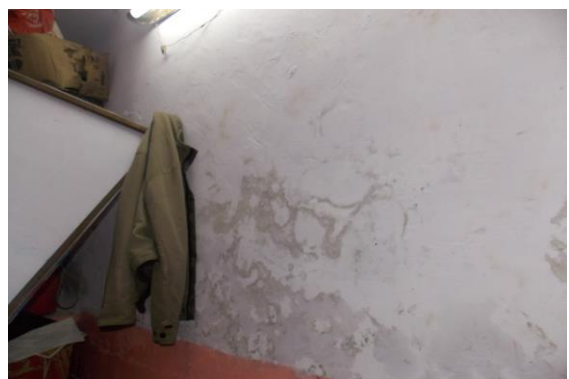
Photo 205
Dampness/Seepage on Wall No. 2 of Shop 1 of Ground Floor

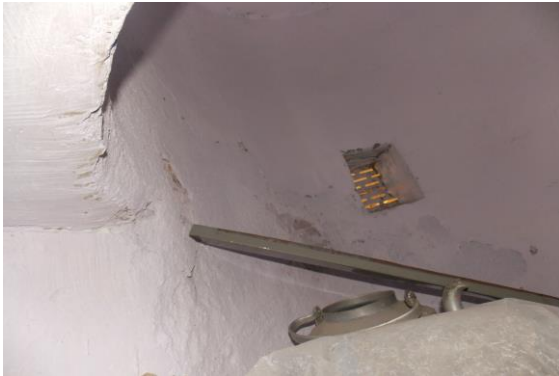
Photo 206

Peeling of Plaster on Wall No. 1 of Tomb in Shop 1 of Ground Floor

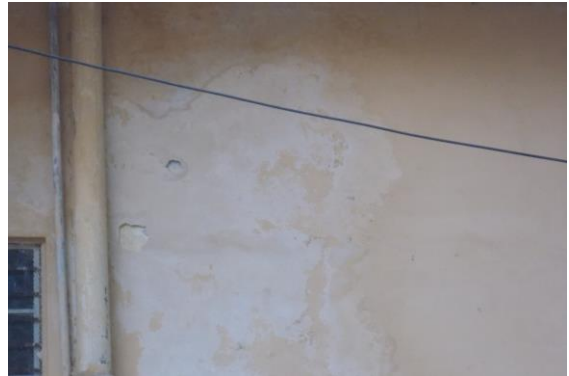
Photo 207

Dampness/Seepage on wall of Ground Floor

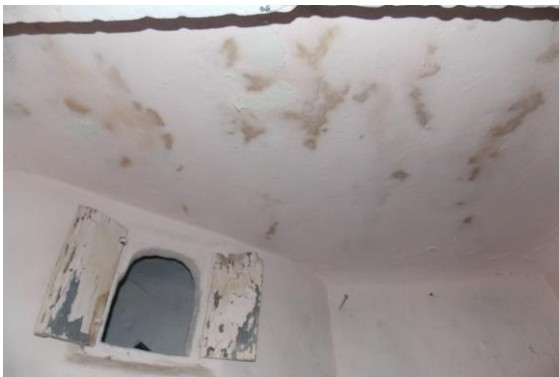
Photo 208

Dampness/Seepage on Roof of Store 1 of First Floor

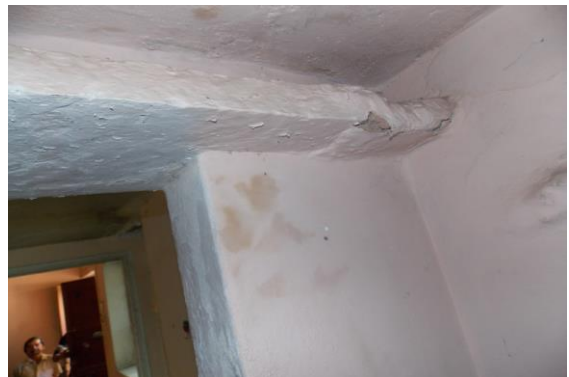
Photo 209

Dampness/Seepage on Wall No. 3 of Store 1 of First Floor

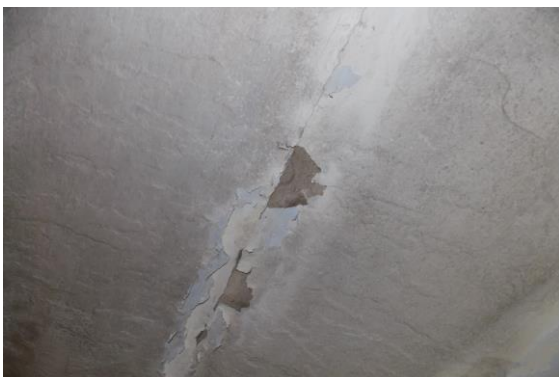
Photo 210

Dampness/Seepage on Roof of Room No. 1 of First Floor

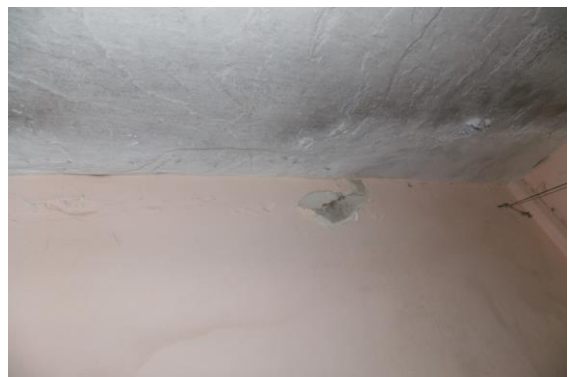
Photo 211

Peeling of Plaster on Wall No. 1 of Room No. 1 of First Floor

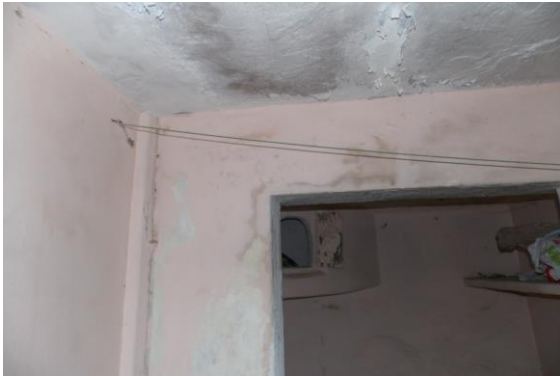
Photo 212

Dampness/Seepage on Wall No. 4 of Room No. 1 of First Floor

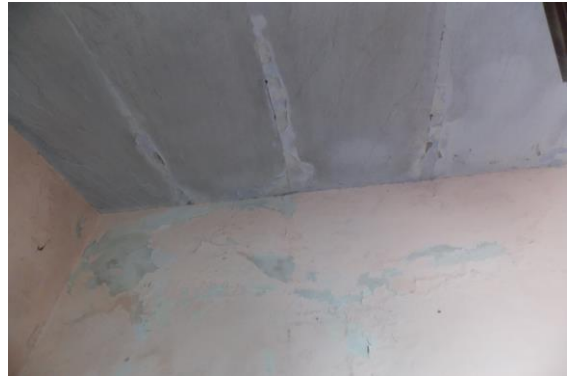
Photo 213

Dampness/Seepage on Wall No. 4 & Roof of Room No. 2 of First Floor

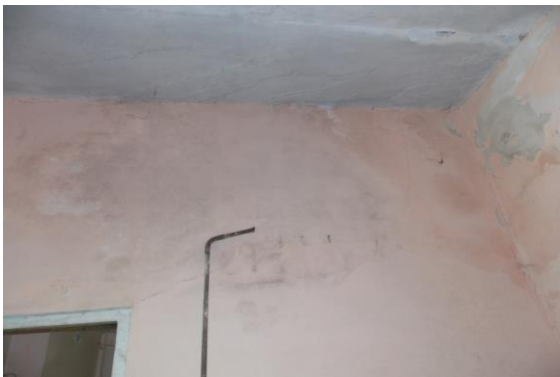
Photo 214

Dampness/Seepage on Wall No. 1 of Room No. 2 of First Floor

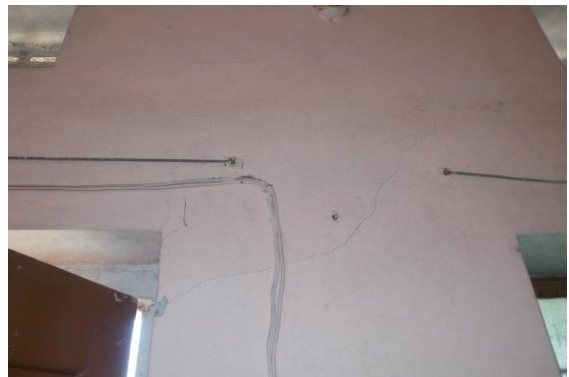
Photo 215

Peeling of Plaster on Wall No. 3 of Room No. 2 of First Floor

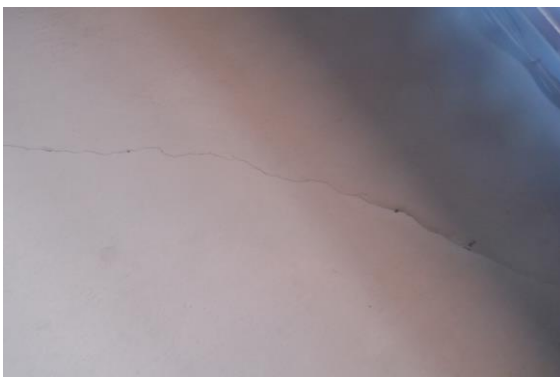
Photo 216

Peeling of Plaster on Wall No. 2 of Room No. 2 of First Floor

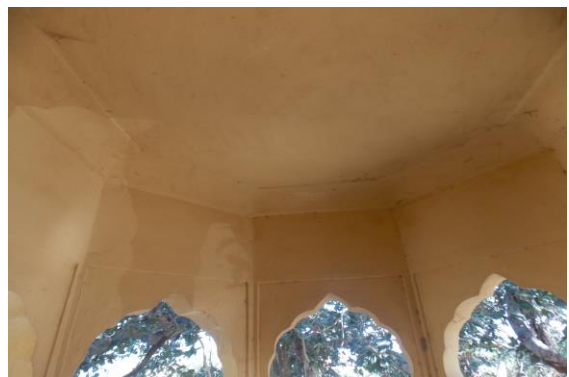
Photo 217

Dampness/Seepage on Wall No. Roof & All Wall of Tomb 1 of First Floor

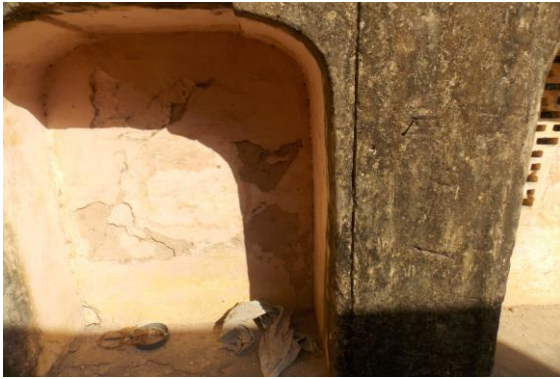
Photo 218
Damaged Portion on Wall No. 1 of Open Area 1 of First Floor

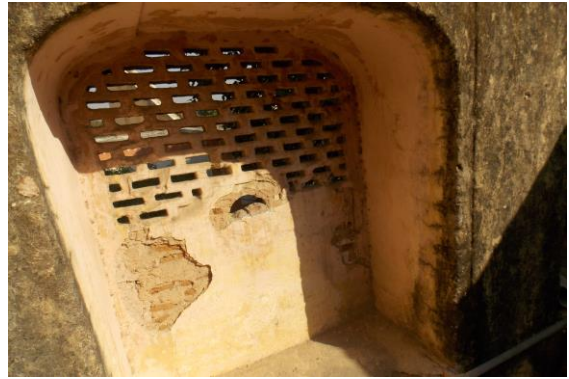
Photo 219
Damaged Portion on Wall No. 1 of Open Area 1 of First Floor

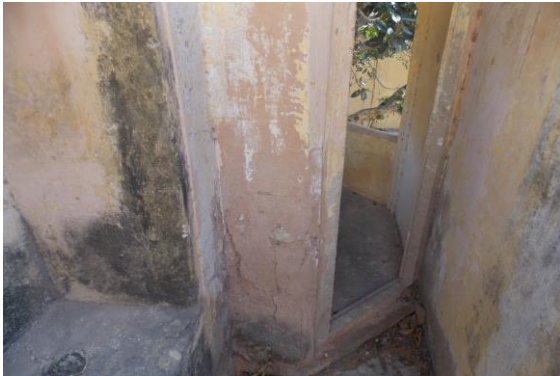
Photo 220
Peeling of Plaster on Wall No. 4 of Open Area 1 of First Floor

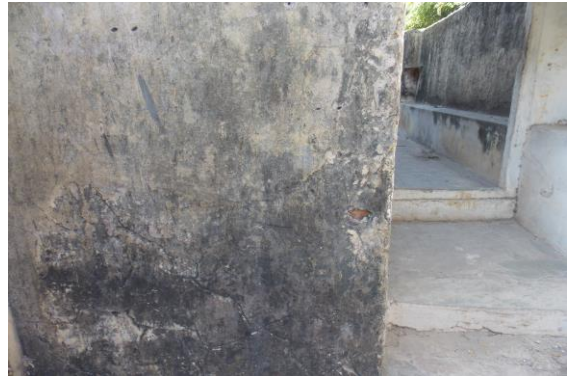
Photo 221
Peeling of Plaster on Wall No. 3 of Open Area 1 of First Floor

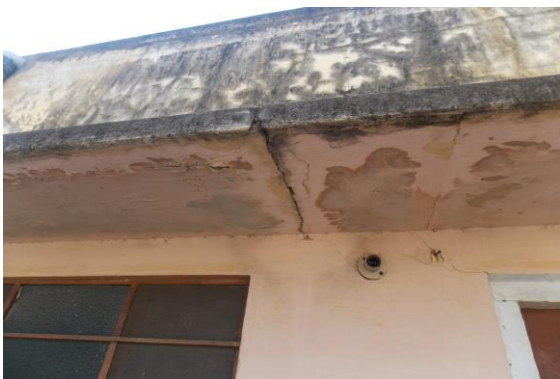
Photo 222
Dampness/Seepage on Sunshade & 2 of Open Area 1 of First Floor

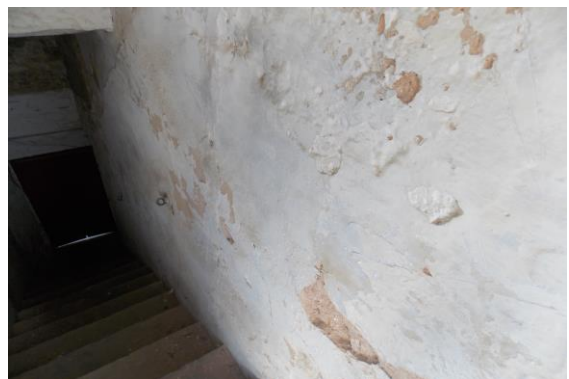
Photo 223
Peeling of Plaster on Wall No. 2 of Stair Case 1 of First Floor

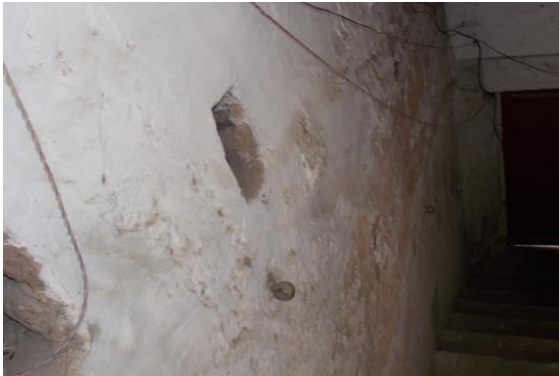
Photo 224

Peeling of Plaster on Wall No. 1 of Stair Case 1 of First Floor

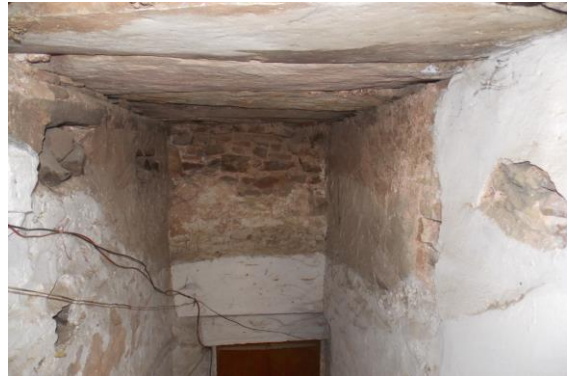
Photo 225

Peeling of Plaster on Wall No. 1, 2, 4 & Roof of Stair Case 1 of First Floor

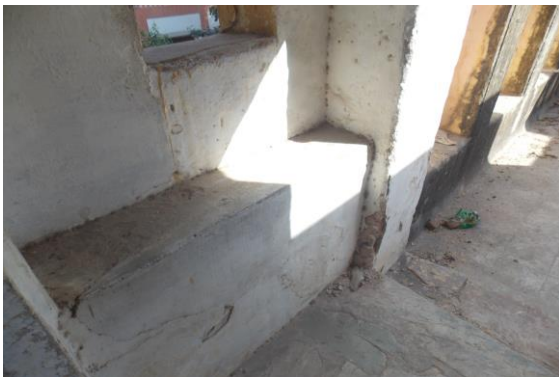
Photo 226

Peeling of Plaster on Wall No. 3 of Stair Case 1 of First Floor

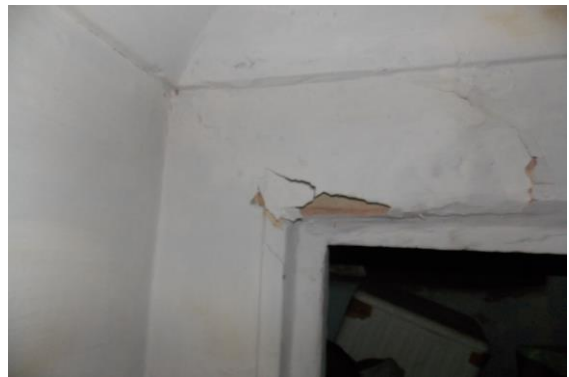
Photo 227

Peeling of Plaster on Wall No. 1 of Store 2 of First Floor

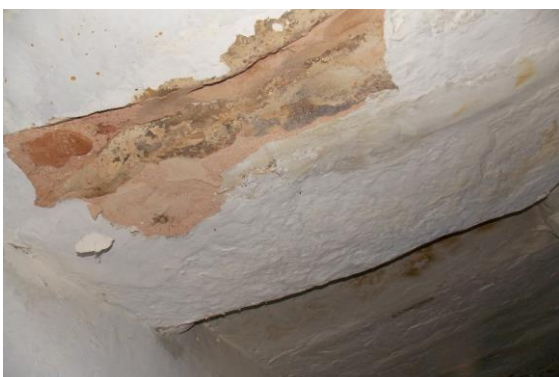
Photo 228

Peeling of Plaster on Roof of Store 2 of First Floor

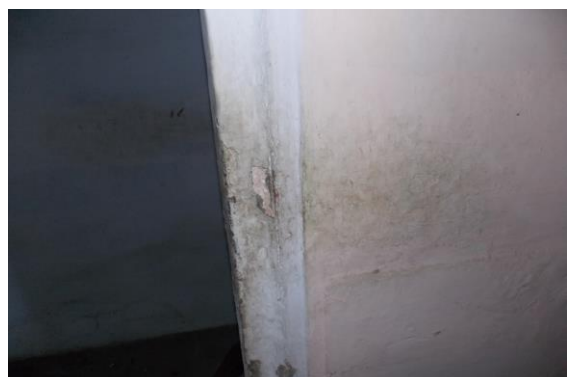
Photo 229

Peeling of Plaster on Wall No. 2 of Room No. 3 of First Floor

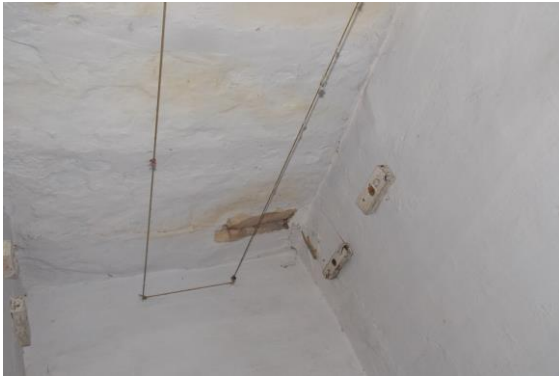
Photo 230
Peeling of Plaster on Roof of Store 3 of First Floor

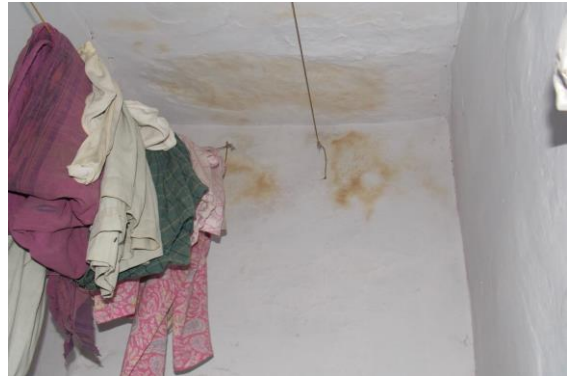
Photo 231
Dampness/Seepage on Wall No. 2 of Store 3 of First Floor

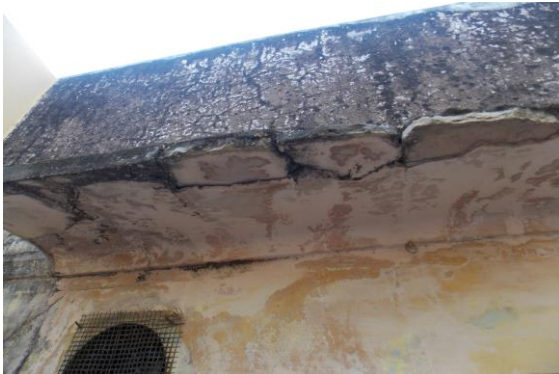
Photo 232
Damaged Portion on Sunshade of Open Area 2 of First Floor

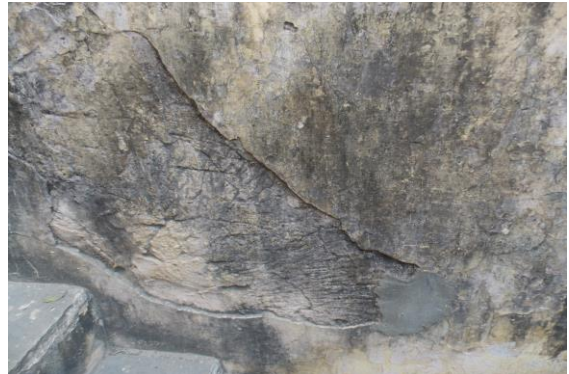
Photo 233
Peeling of Plaster on Wall No. 1 of Open Area 2 of First Floor

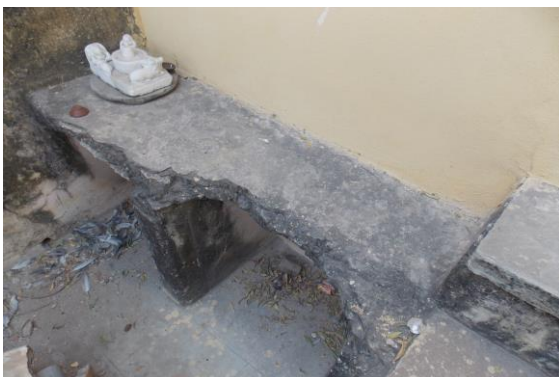
Photo 234
Damaged Portion on Wall No. 3 of Open Area 2 of First Floor

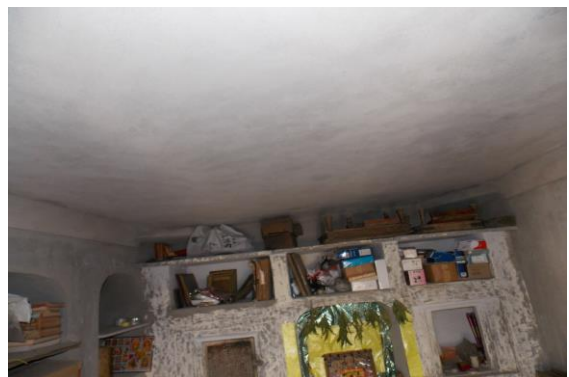
Photo 235
Dampness/Seepage of Room No. 5 of First Floor

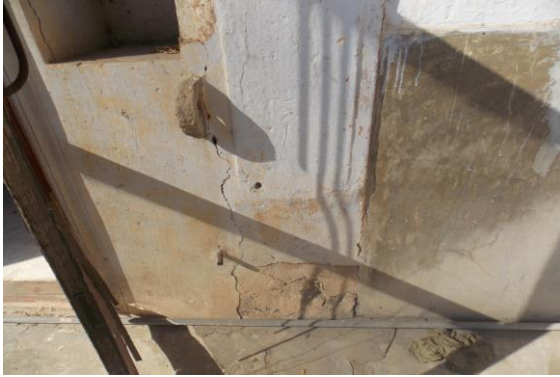
Photo 236
Peeling of Plaster on Wall No. 3 of Open Area 3 of First Floor

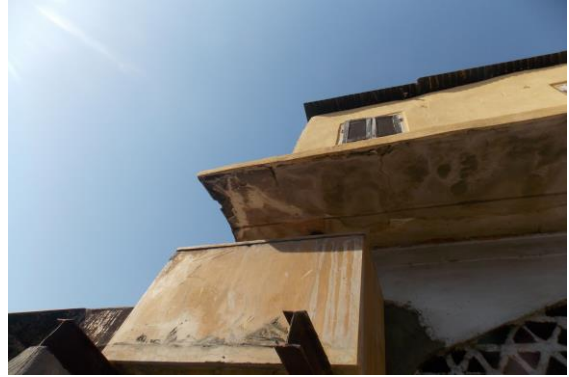
Photo 237
Peeling of Plaster on Sunshade & 3 of Open Area 3 of First Floor

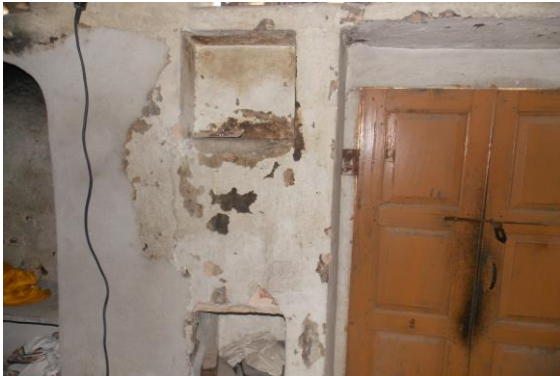
Photo 238
Dampness/Seepage on Wall No. 4 of Room No. 6 of First Floor

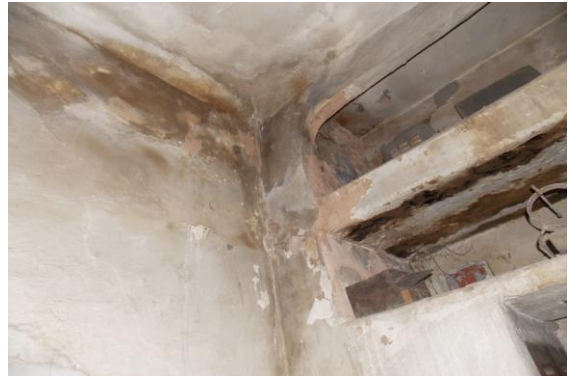
Photo 239
Dampness/Seepage on Wall No. 3 of Room No. 6 of First Floor

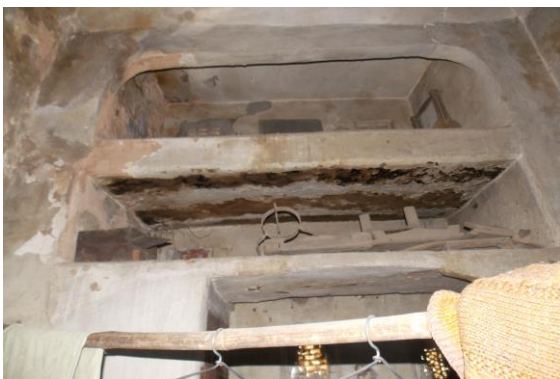
Photo 240
Dampness/Seepage on Wall No. 1 of Room No. 6 of First Floor

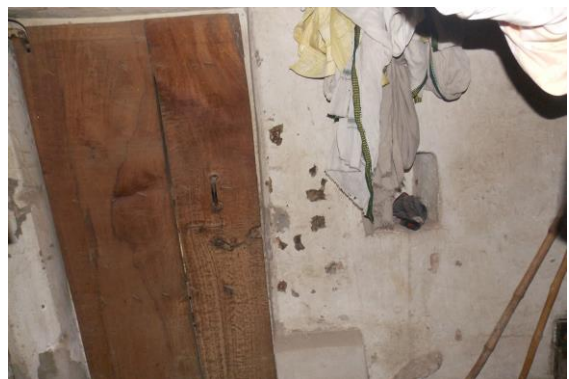
Photo 241
Dampness/Seepage on Wall No. 2 of Room No. 6 of First Floor

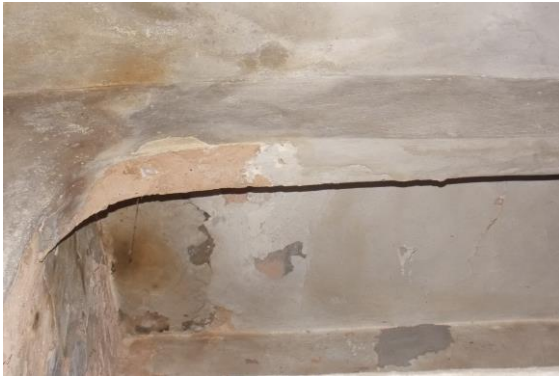
Photo 242
Dampness/Seepage on Roof of Room No. 6 of First Floor

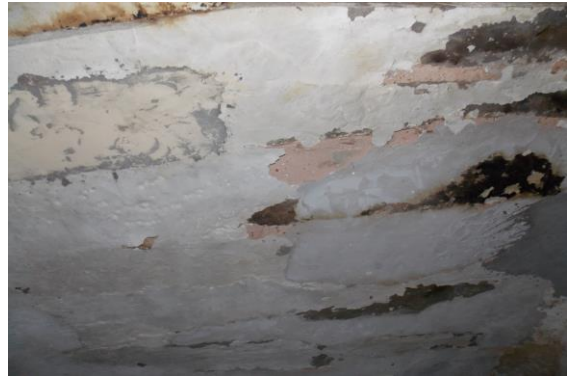
Photo 243
Peeling of Plaster on Roof of Kitchen of First Floor

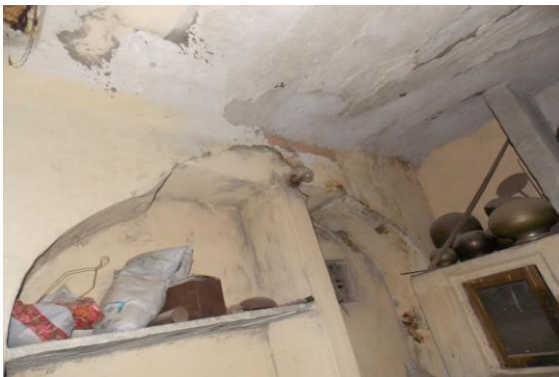
Photo 244
Peeling of Plaster on Wall No. 1 of Kitchen of First Floor

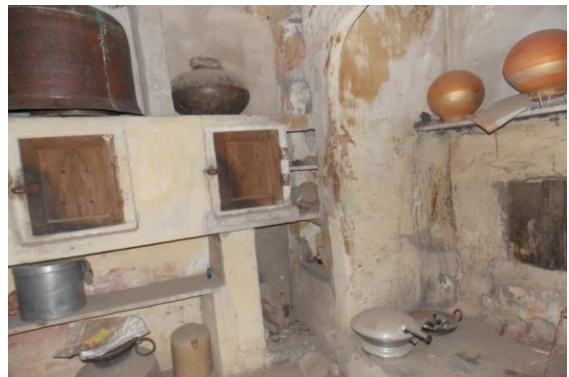
Photo 245
Peeling of Plaster on Wall No. 4 of Kitchen of First Floor

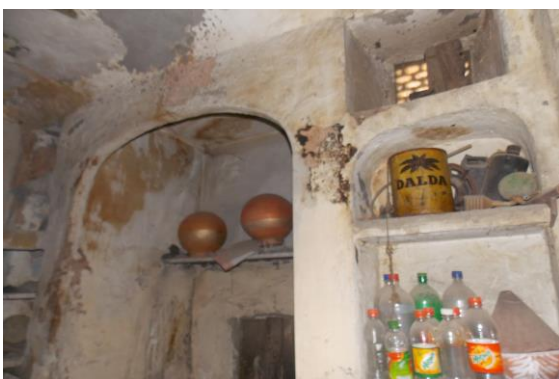
Photo 246
Dampness/Seepage on Wall No. 2 of Kitchen of First Floor

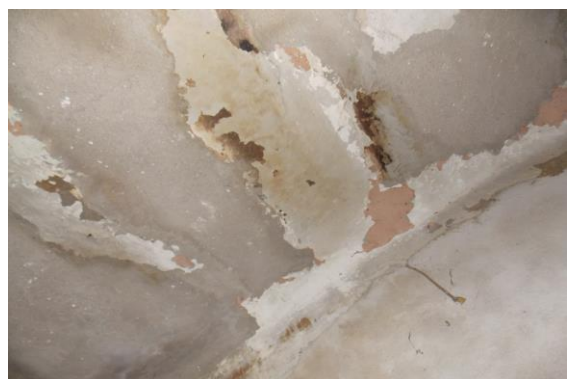
Photo 247
Peeling of Plaster on Roof of Room No. 7 of First Floor

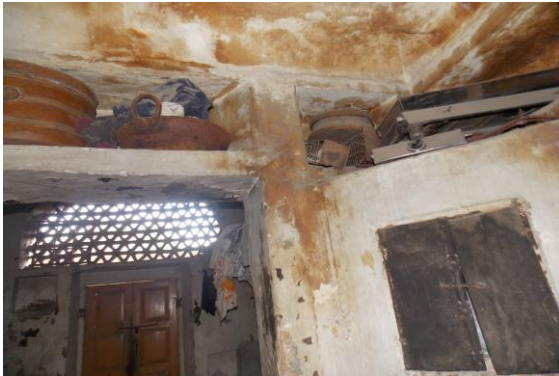
Photo 248
Dampness/Seepage on Wall No. 3 of Room No. 7 of First Floor

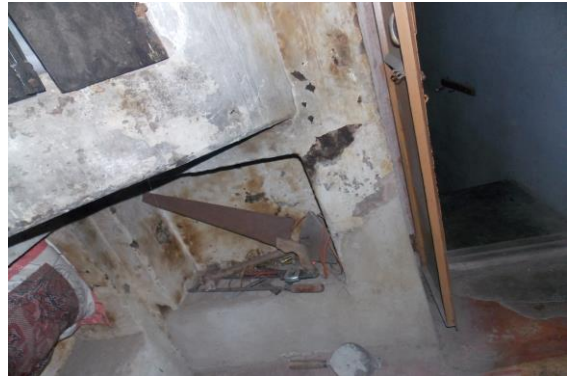
Photo 249
Dampness/Seepage on Wall No. 1 of Room No. 7 of First Floor

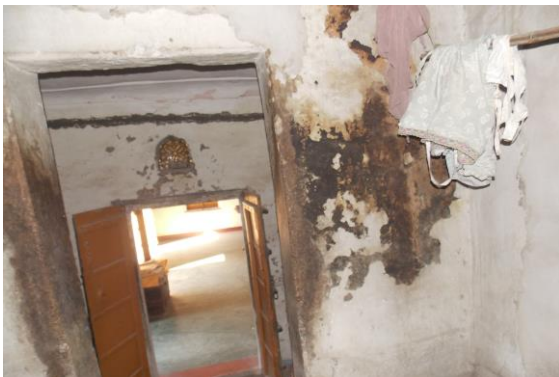
Photo 250
Dampness/Seepage on Wall No. 4 of Room No. 7 of First Floor

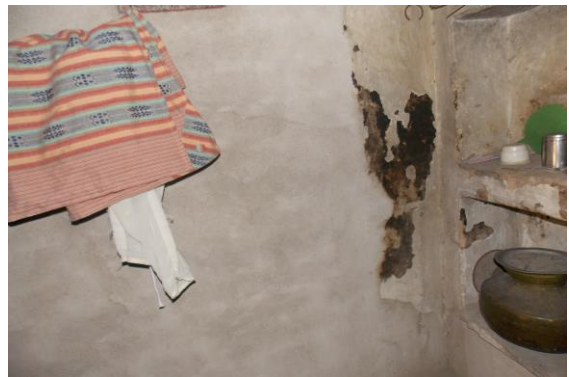
Photo 251
Dampness/Seepage on Wall No. 2 of Room No. 7 of First Floor

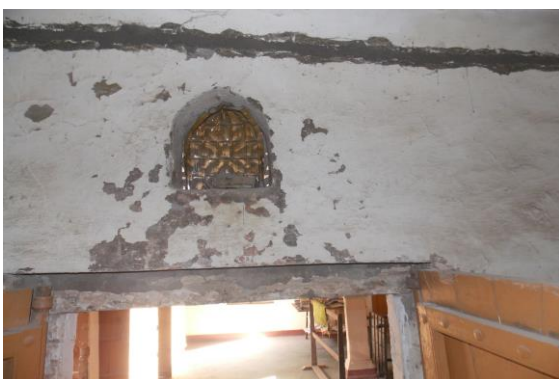
Photo 252
Peeling of Plaster on Wall No. 3 of Store 5 of First Floor

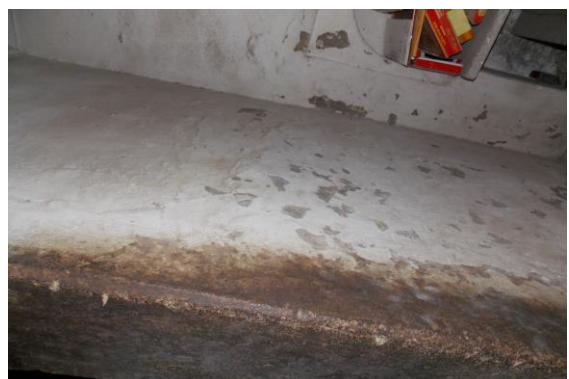
Photo 253
Peeling of Plaster on Wall No. 2 of Store 5 of First Floor

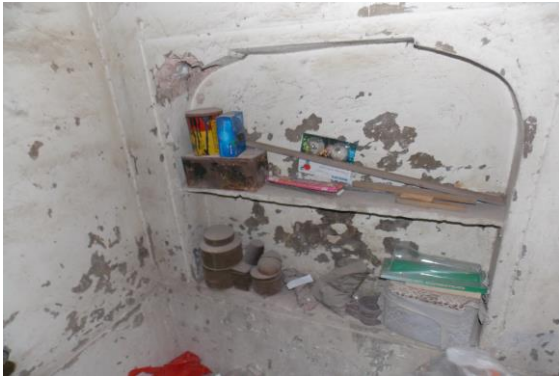
Photo 254

Peeling of Plaster on Wall No. 1 of Store 5 of First Floor

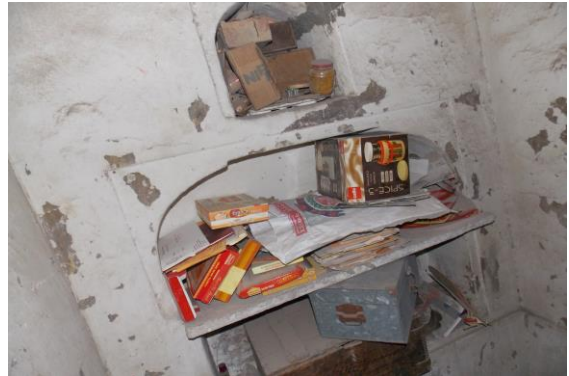
Photo 255

Peeling of Plaster on Wall No. 2 of Store 5 of First Floor

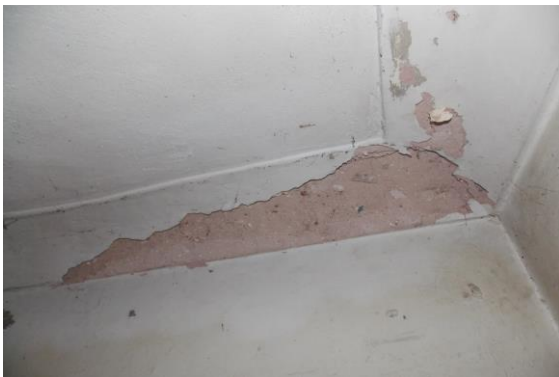
Photo 256

Peeling of Plaster on Roof of Store 5 of First Floor

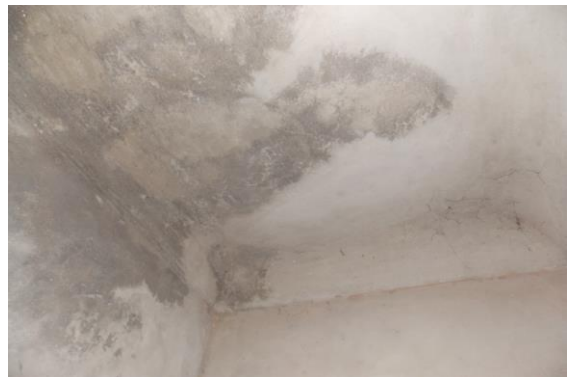
Photo 257

Dampness/Seepage on All Wall of Tomb 2 of First Floor

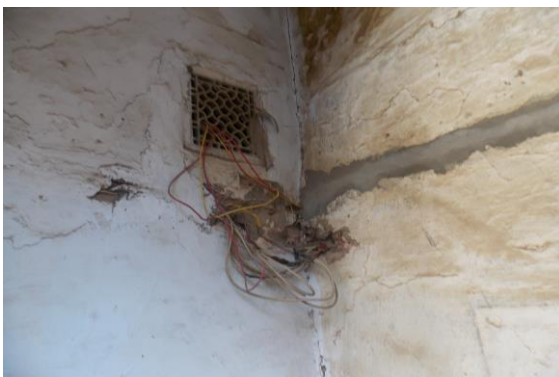
Photo 258

Peeling of Plaster on Wall No. 1 & 3 of Open Area 4 of First Floor

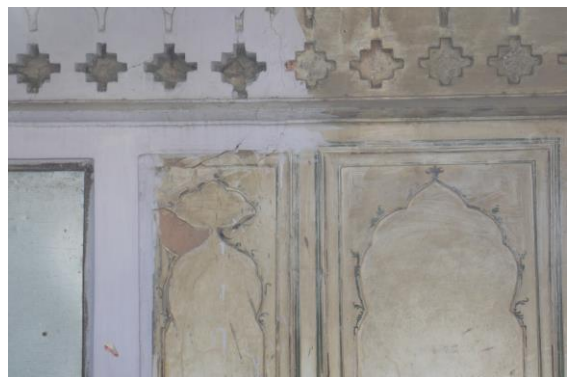
Photo 259

Peeling of Plaster on Wall No. 4 of Open Area 4 of First Floor

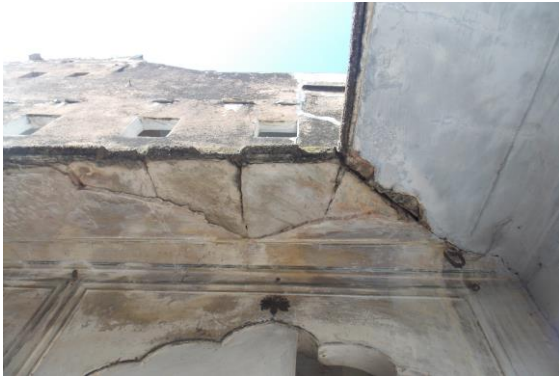
Photo 260

Damaged Portion on Sunshade & 2 of Open Area 4 of First Floor

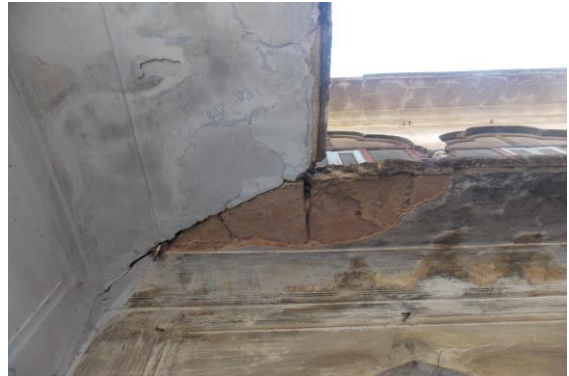
Photo 261

Damaged Portion on Sunshade & 2 of Open Area 4 of First Floor

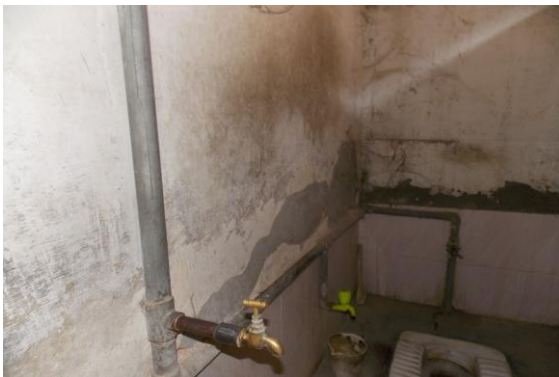
Photo 262

Damaged Portion on Wall No. 1 of Toilet No. 6 of First Floor

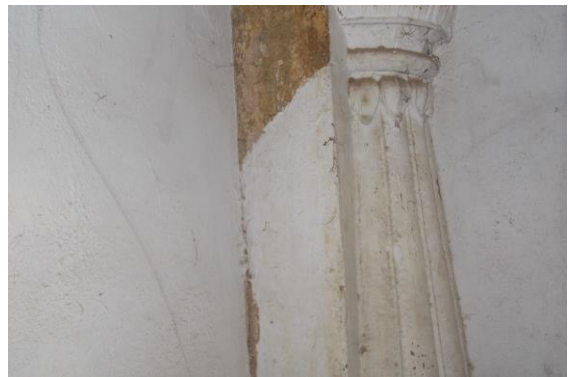
Photo 263

Peeling of Plaster on Wall No. 3 of Bathroom of First Floor

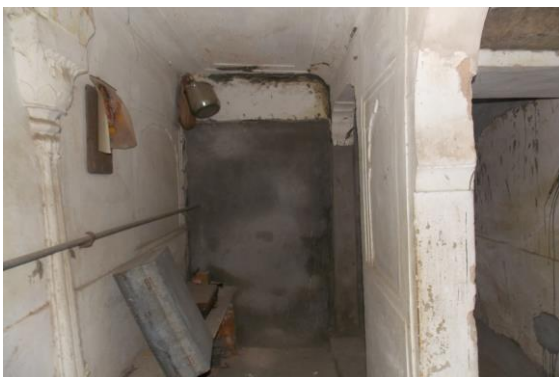
Photo 264

Damaged Portion on Wall No. 4 of Passage 1 of First Floor

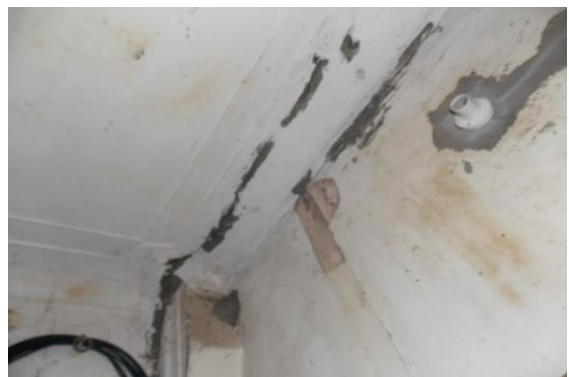
Photo 265

Peeling of Plaster on Roof & 1 of Passage 1 of First Floor

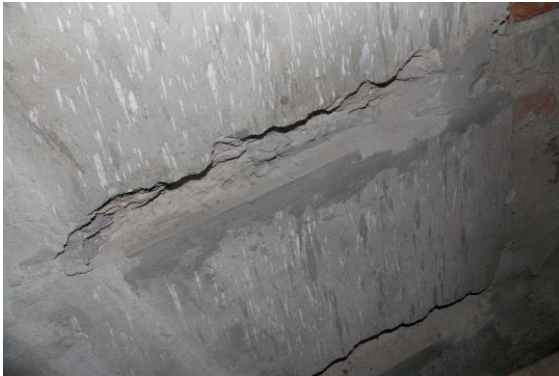
Photo 266
Peeling of Plaster on Wall No. 2 of Passage 1 of First Floor

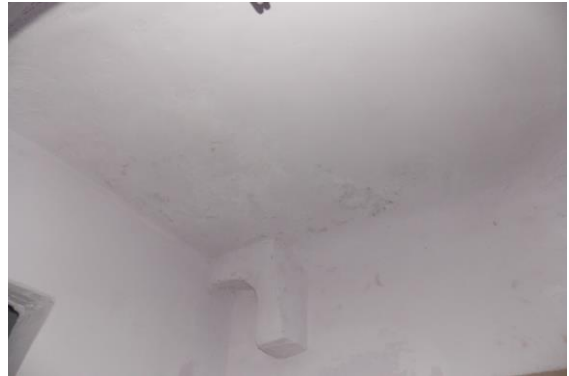
Photo 267
Dampness/Seepage on Roof of Bathroom of First Floor

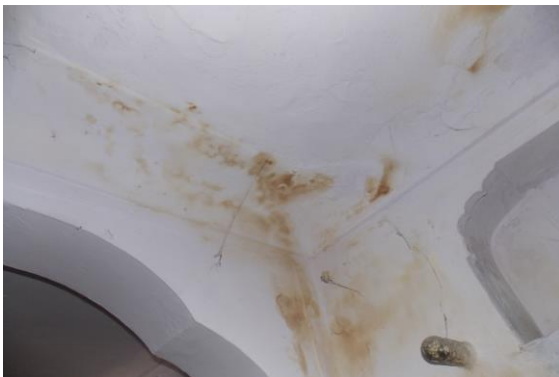
Photo 268
Dampness/Seepage on Roof of Room No. 11 of First Floor

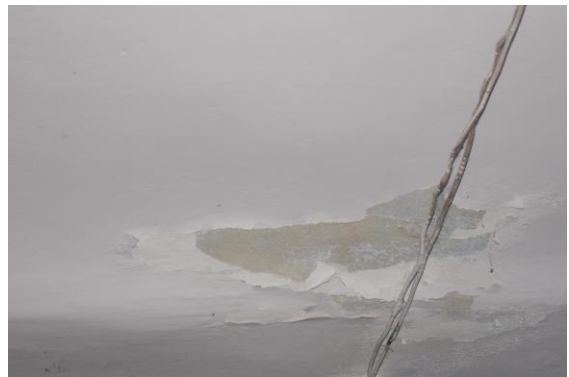
Photo 269
Peeling of Plaster on Roof of Room No. 12 of First Floor

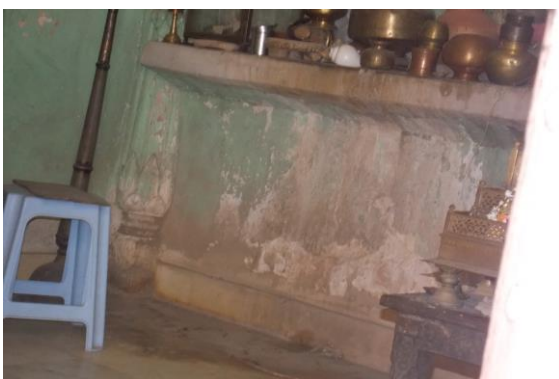
Photo 270
Peeling of Plaster on Wall No. 2 of Temple Area of First Floor

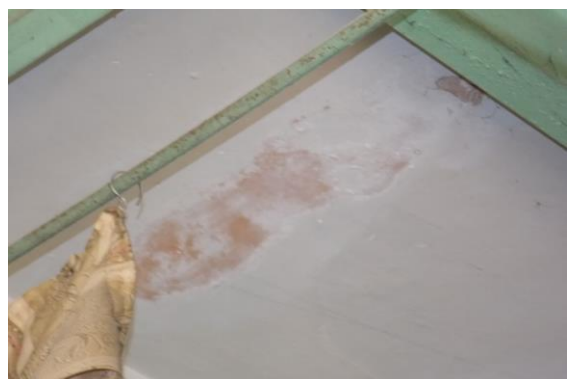
Photo 271
Peeling of Plaster on Roof of Temple Area of First Floor

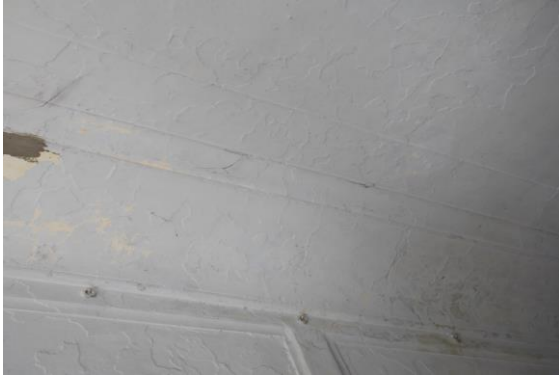
Photo 272
Dampness/Seepage on Roof of Veranda of First Floor

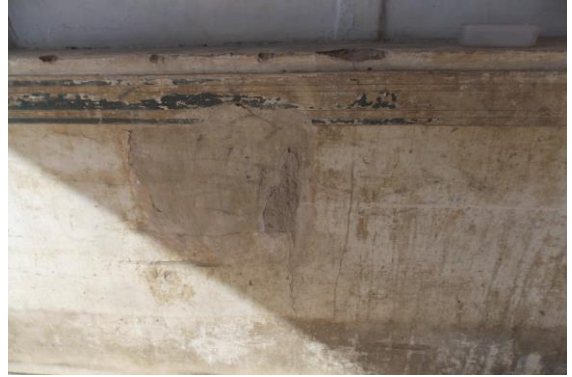
Photo 273
Peeling of Plaster on Wall No. 1 of Veranda of First Floor

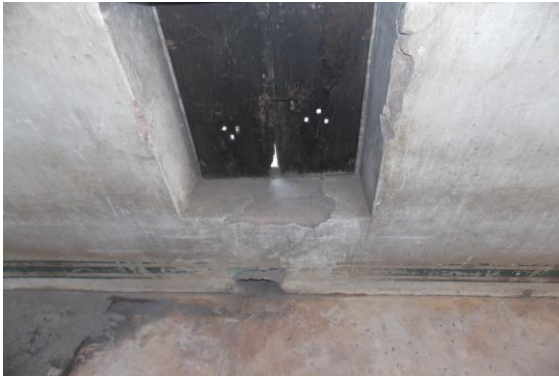
Photo 274
Peeling of Plaster on Wall No. 2 of Veranda of First Floor

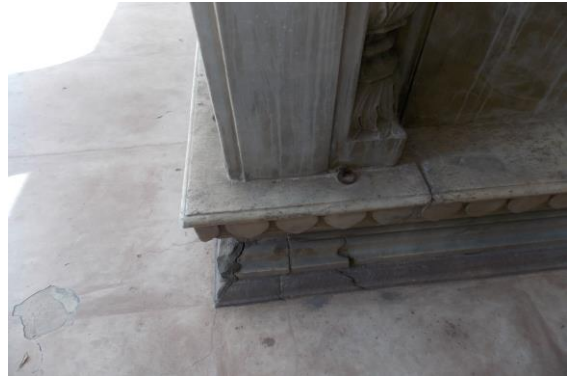
Photo 275
Damaged Portion on Wall No. 8 of Veranda of First Floor

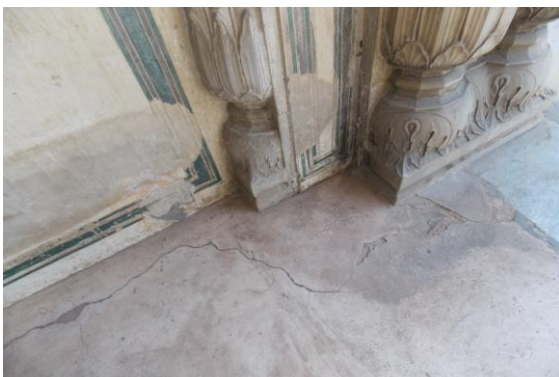
Photo 276
Peeling of Plaster on Floor of Veranda of First Floor

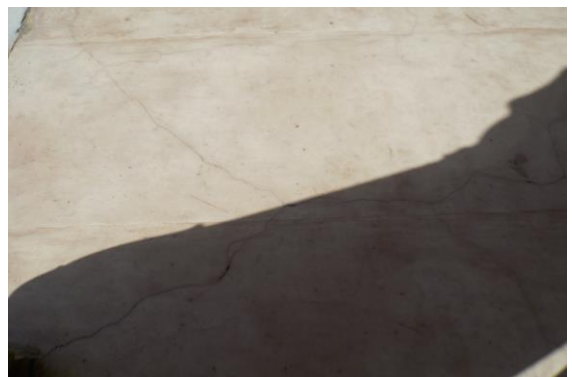
Photo 277
Peeling of Plaster on Floor of Veranda of First Floor

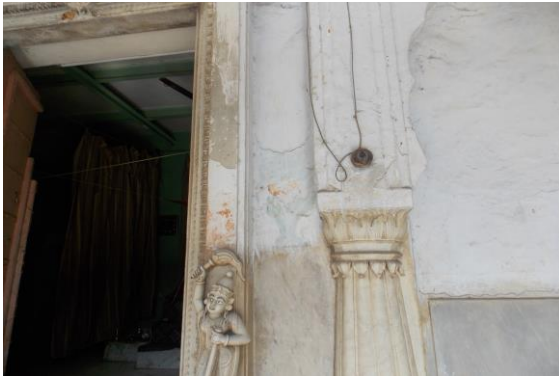
Photo 278
Peeling of Plaster on Wall No. 5 of Veranda of First Floor

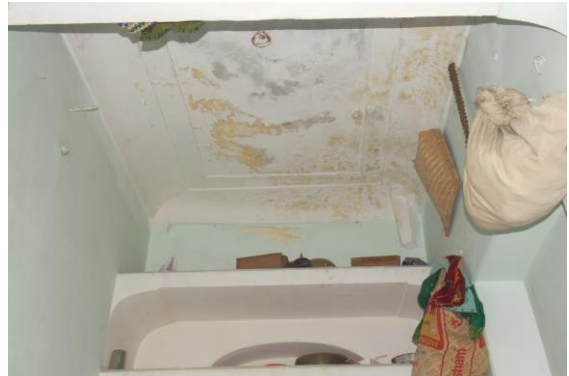
Photo 279
Dampness/Seepage on Roof of Kitchen 2 of First Floor

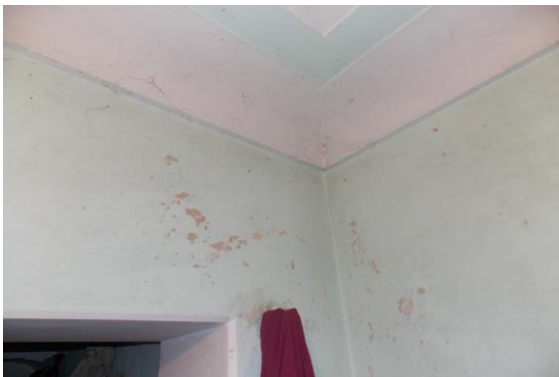
Photo 280
Peeling of Plaster on Wall No. 1 & 4 of Room No. 14 of First Floor

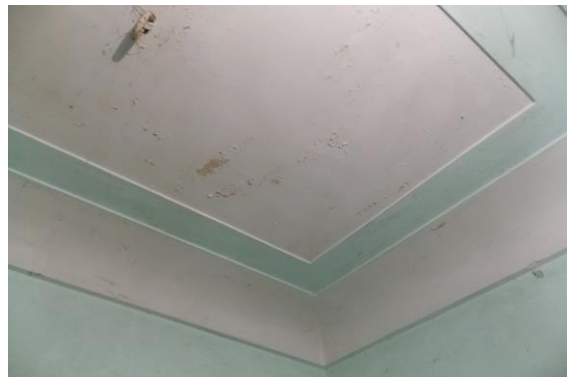
Photo 281
Peeling of Plaster on Roof of Room No. 14 of First Floor

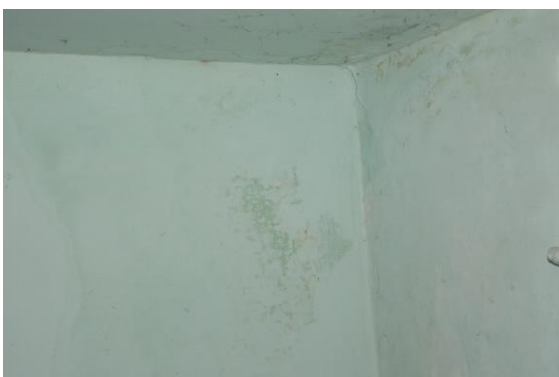
Photo 282
Peeling of Plaster on Wall No. 4 of Store 9 of First Floor

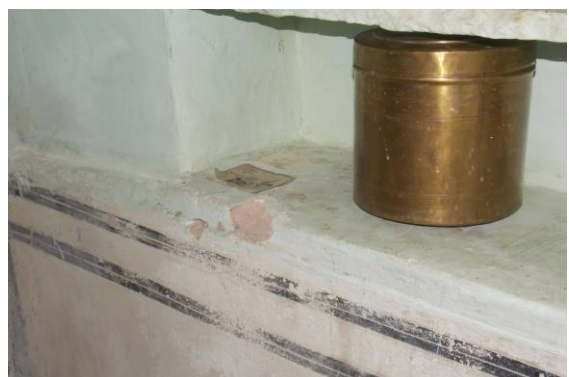
Photo 283
Peeling of Plaster on Wall No. 2 of Store 9 of First Floor

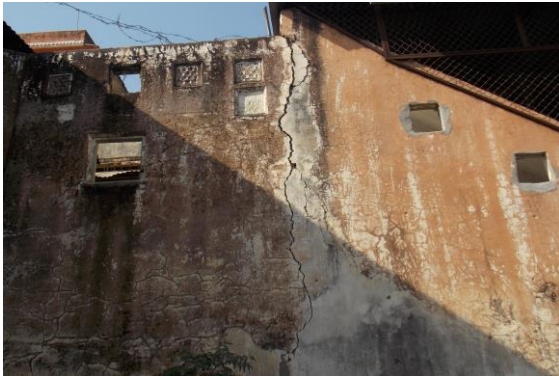
Photo 284
Damaged Portion on Wall No. 4 of Open Area 6 of First Floor

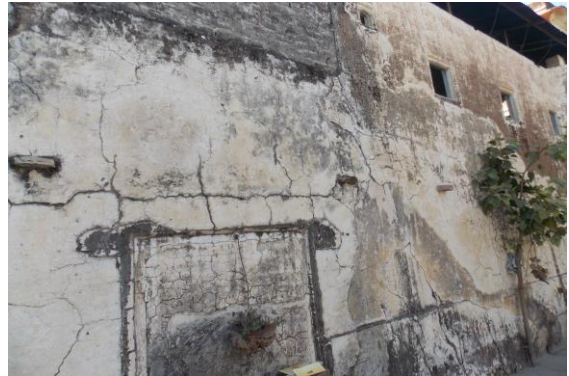
Photo 285
Damaged Portion on Wall No. 1 of Open Area 6 of First Floor

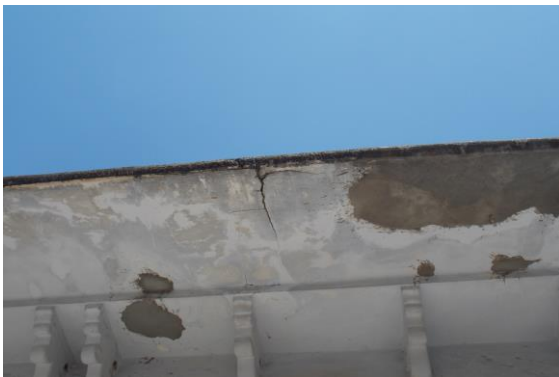
Photo 286
Damaged Portion on Sunshade of Open Area 6 of First Floor

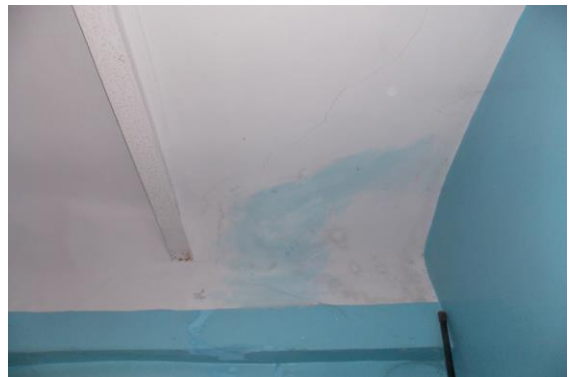
Photo 287
Dampness/Seepage on Roof of Room No. 16 of First Floor

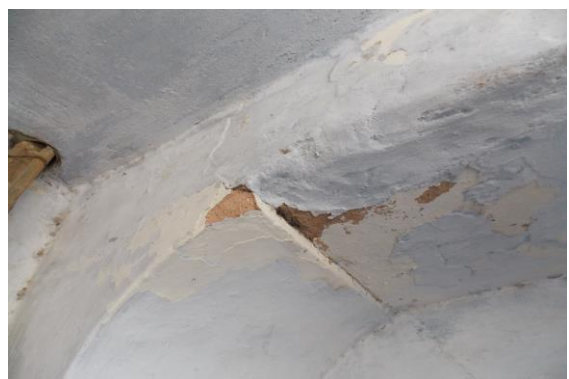
Photo 289
Peeling of Plaster on Roof of Gate of First Floor

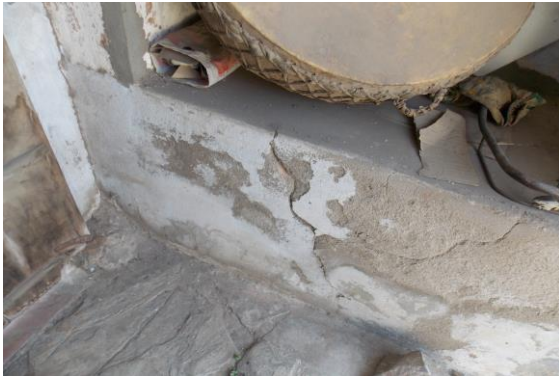
Photo 290
Damaged Portion on Wall No. 1 of Gate of First Floor

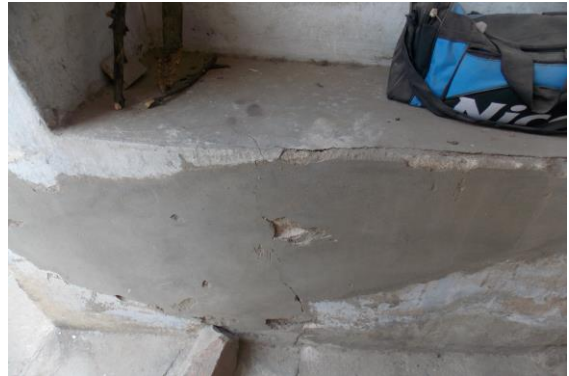
Photo 291
Damaged Portion on Wall No. 2 of Gate of First Floor

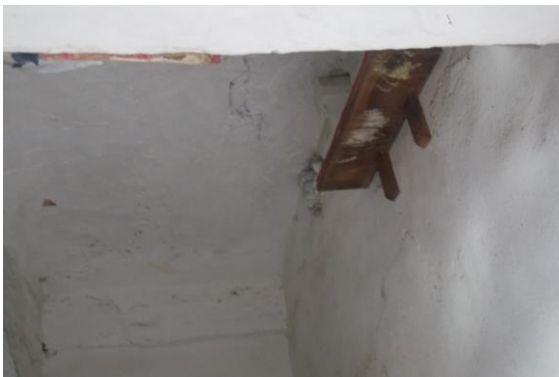
Photo 292
Peeling of Plaster on Roof of Room No. 17 of First Floor

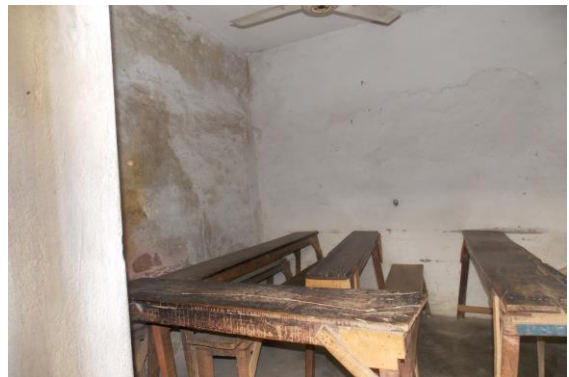
Photo 293
Peeling of Plaster on Wall No. 1 of Room No. 17 of First Floor

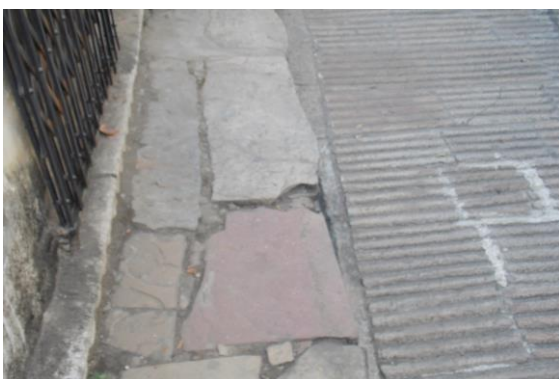
Photo 294
Damaged Portion on Floor of Room No. 17 of First Floor

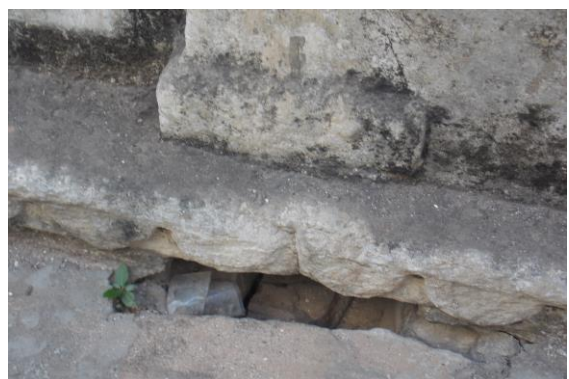
Photo 295
Damaged Portion on Floor of Room No. 17 of First Floor

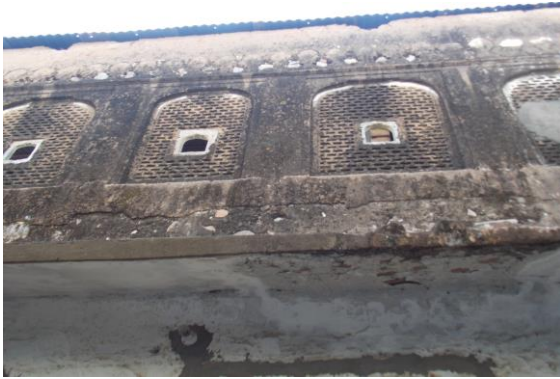
Photo 296
Peeling of Plaster on of Entry Door of R 17 & 18 of First Floor

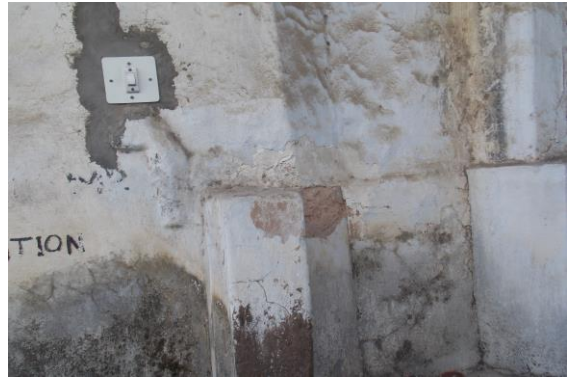
Photo 297
Peeling of Plaster on of Entry Door of R 17 & 18 of First Floor
