Pre Building Condition Survey Report

Name and Address of Structure :	Choti Chopar to Badi Chopar (UP Line)
---------------------------------	---------------------------------------

Name of the Project	Contract JMRC-UG1B “Design and Construction of Tunnel between Chandpole and Badi Chouper and reverse line by Shield TBM, Underground Metro Stations at Choti Chouper and Badi Chouper by Cut and Cover Methods on East West Corridor of Jaipur Metro Rail Corporation Limited .”	
Owner :

Shoping Complex - Shop No. 169-188
Tripolia Bazar
Jaipur
Unique ID: CC BC UP 0001

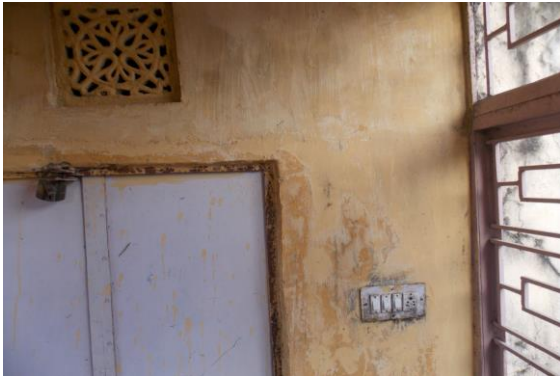
Photo 298
Dampness/Seepage on Room No. 20 of First Floor

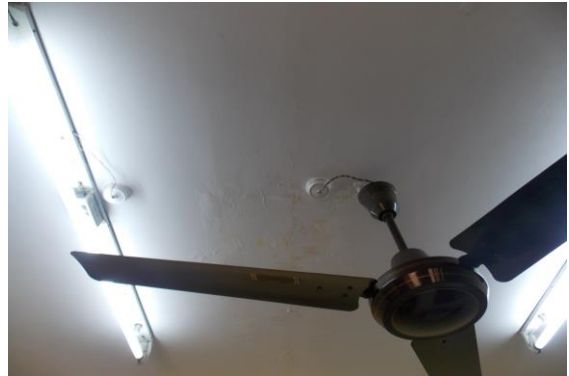
Photo 299
Dampness/Seepage on Roof of Room No. 20 of First Floor

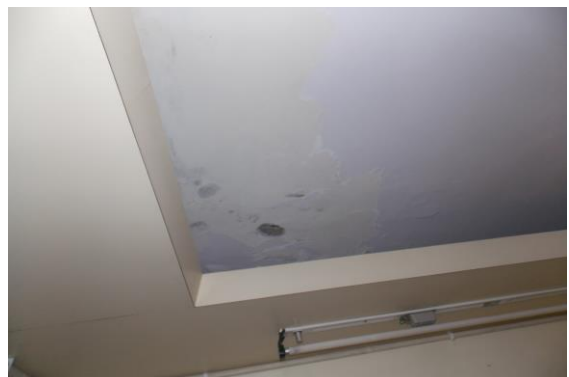
Photo 301
Dampness/Seepage on Roof of Room No. 22 of First Floor

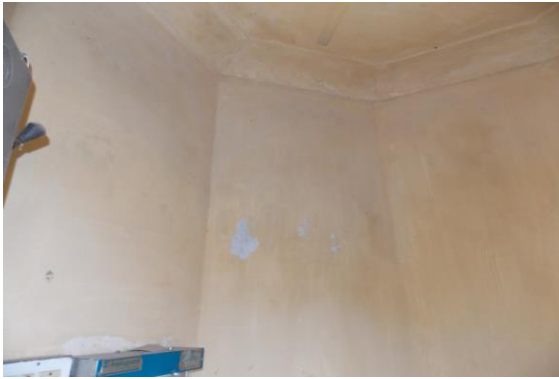
Photo 302
Peeling of Plaster on Wall No. 4 of Tomb 3 of First Floor

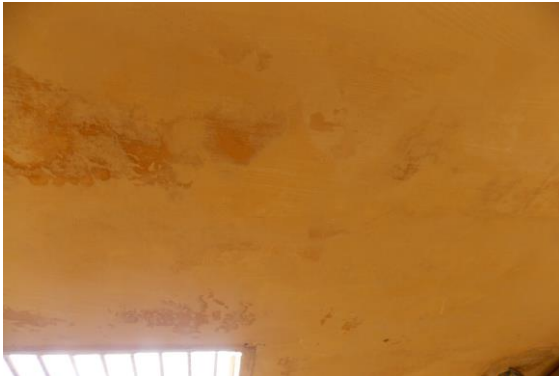
Photo 304
Dampness/Seepage on Roof of Passage 2 of First Floor

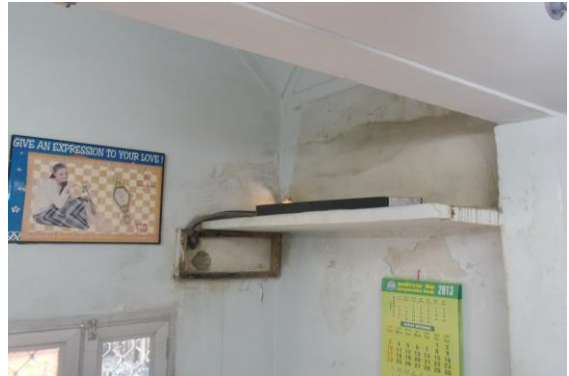
Photo 305
Peeling of Plaster on Wall No. 4 & 5 of Room No. 23 of First Floor

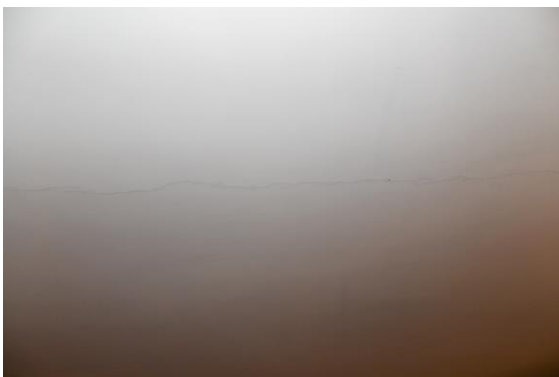
Photo 306
Plaster Crack on Roof of Room No. 25 of First Floor

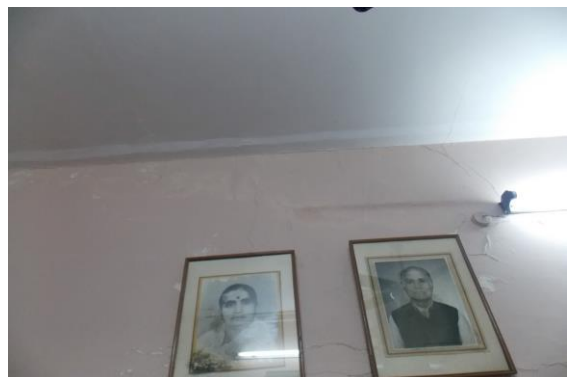
Photo 307
Peeling of Plaster on Wall No. 2 of Room No. 24 of First Floor

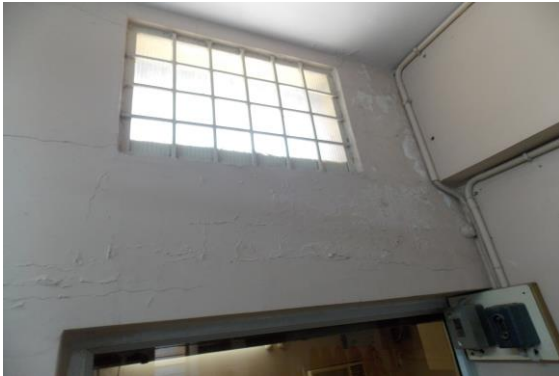
Photo 308
Peeling of Plaster on Wall No. 2 of Room No. 26 of First Floor

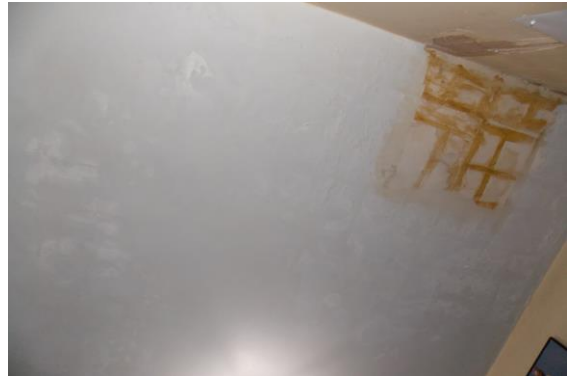
Photo 309
Dampness/Seepage on Roof of Room No. 27 of First Floor

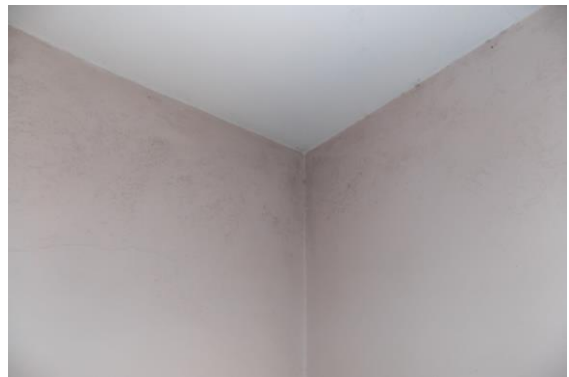
Photo 311
Dampness/Seepage on Wall No. 1 & 4 of Room No. 28 of First Floor

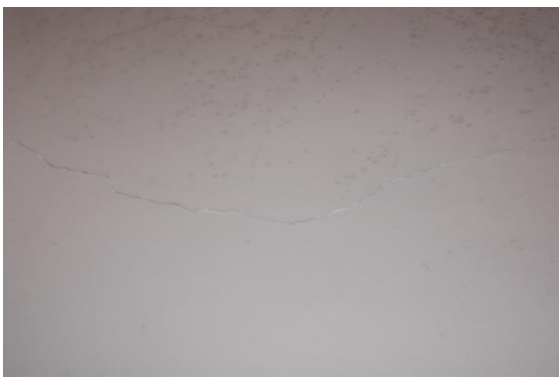
Photo 312
Plaster Crack on Wall No. 1 of Room No. 28 of First Floor

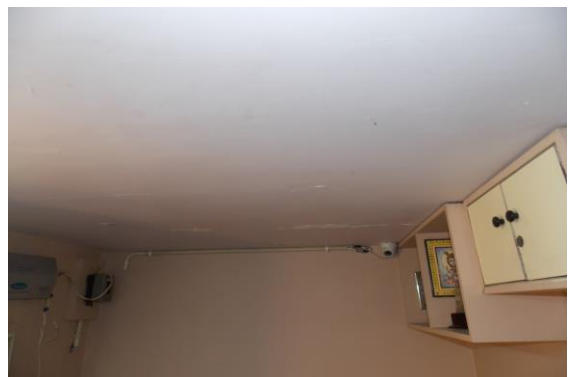
Photo 313
Peeling of Plaster on Roof of Room No. 29 of First Floor

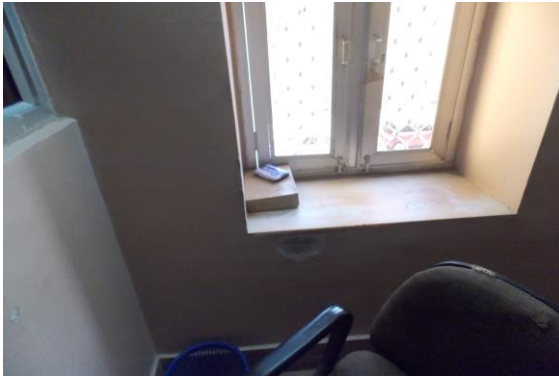
Photo 314
Peeling of Plaster on Wall No. 1 of Room No. 29 of First Floor

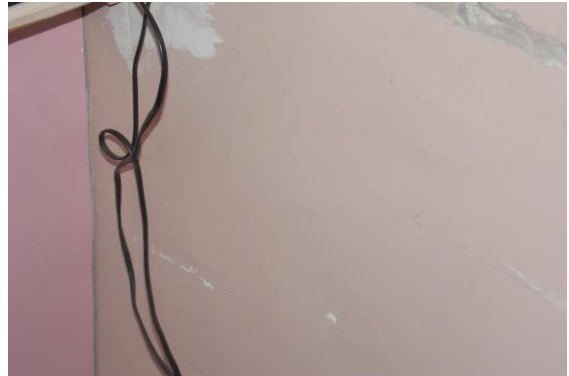
Photo 315
Plaster Crack on Wall No. 2 of Room No. 29 of First Floor

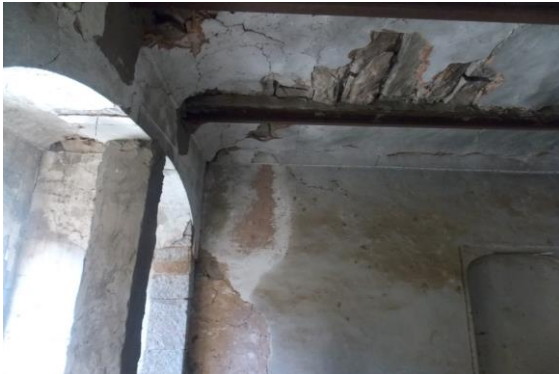
Photo 316
Damaged Portion on Roof All Wall of Varanda (Outer Side) of First Floor

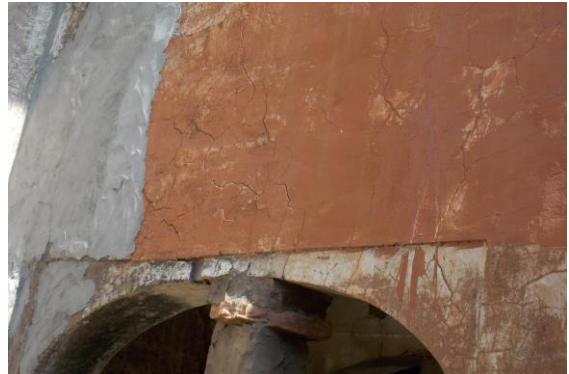
Photo 317
Damaged Portion on Roof All Wall of Varanda (Outer Side) of First Floor

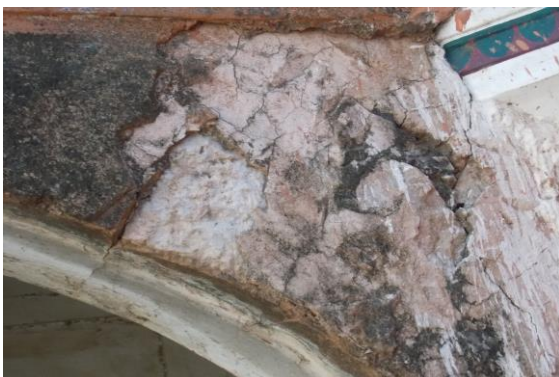
Photo 318
Damaged Portion on Roof All Wall of Varanda (Outer Side) of First Floor

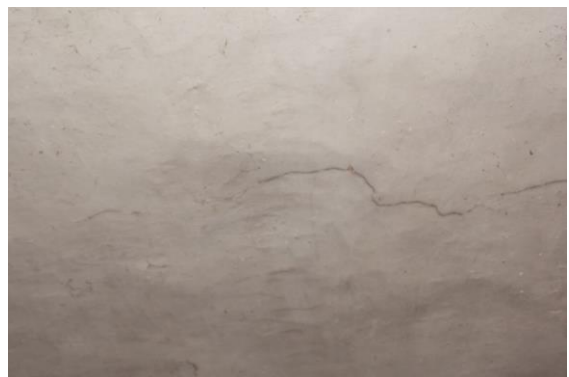
Photo 319
Damaged Portion on Roof All Wall of Varanda (Outer Side) of First Floor

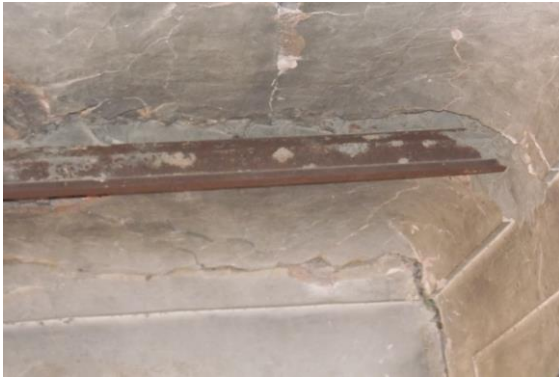
Photo 320

Damaged Portion on Roof All Wall of Varanda (Outer Side) of First Floor

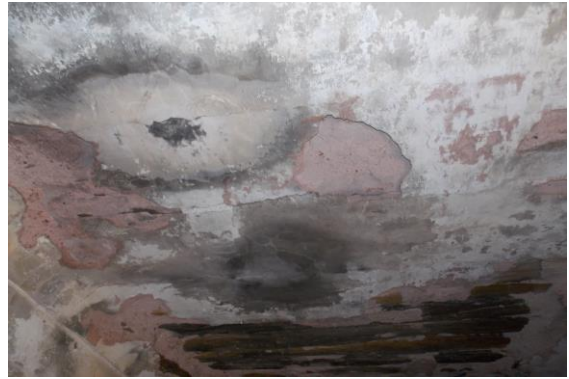
Photo 321

Damaged Portion on Roof All Wall of Varanda (Outer Side) of First Floor

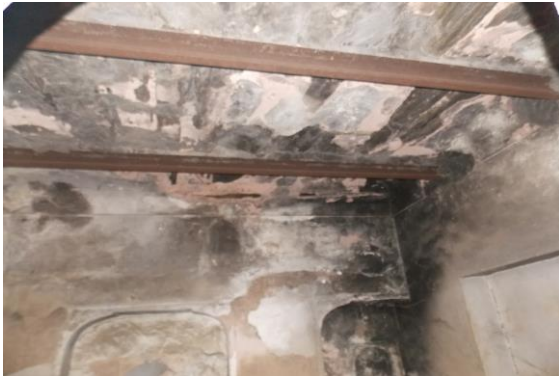
Photo 322

Damaged Portion on Roof All Wall of Varanda (Outer Side) of First Floor

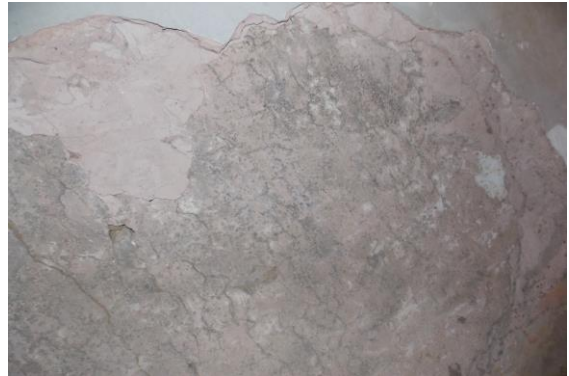
Photo 323

Damaged Portion on Roof All Wall of Varanda (Outer Side) of First Floor

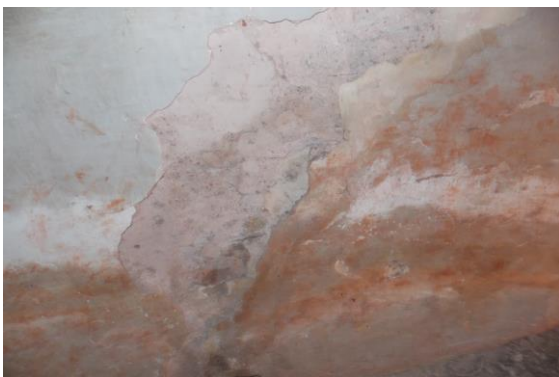
Photo 324

Damaged Portion on Roof All Wall of Varanda (Outer Side) of First Floor

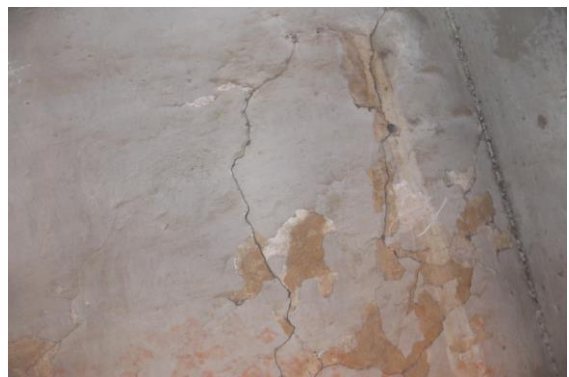
Photo 325

Damaged Portion on Roof All Wall of Varanda (Outer Side) of First Floor

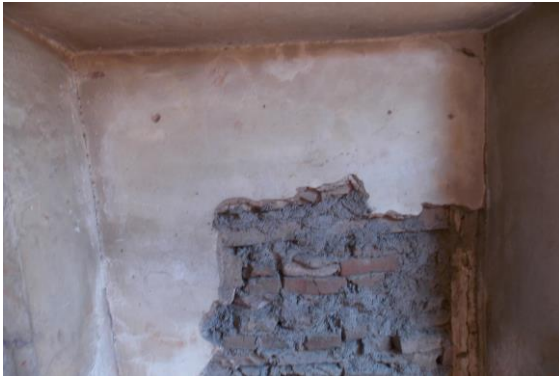
Photo 326

Damaged Portion on Roof All Wall of Varanda (Outer Side) of First Floor

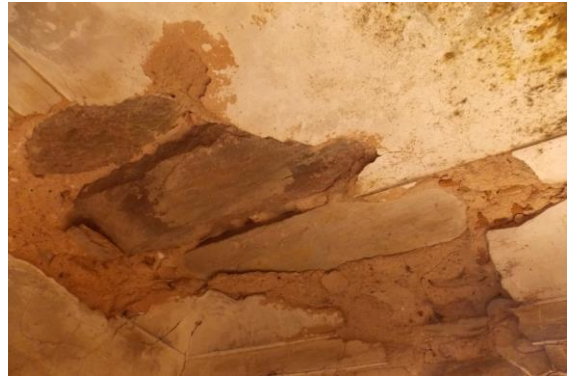
Photo 327

Damaged Portion on Roof All Wall of Varanda (Outer Side) of First Floor

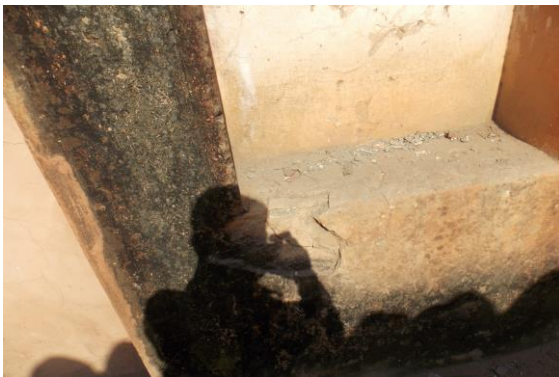
Photo 328

Damaged Portion on Roof All Wall of Varanda (Outer Side) of First Floor

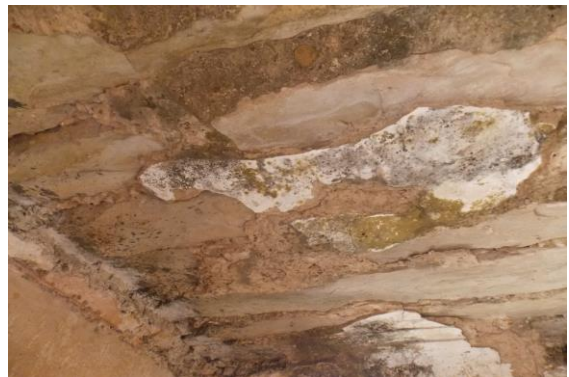
Photo 329

Damaged Portion on Roof All Wall of Varanda (Outer Side) of First Floor

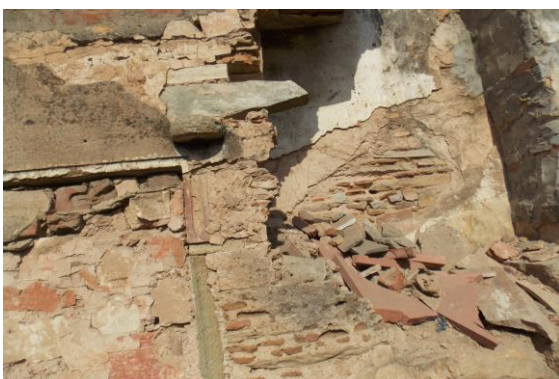
Photo 330

Damaged Portion on Roof All Wall of Varanda (Outer Side) of First Floor

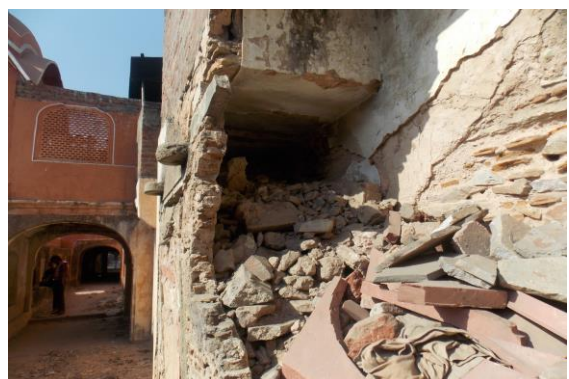
Photo 331

Damaged Portion on Roof All Wall of Varanda (Outer Side) of First Floor

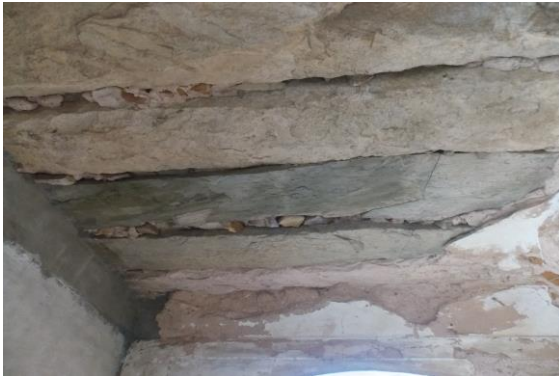
Photo 332

Damaged Portion on Roof All Wall of Varanda (Outer Side) of First Floor

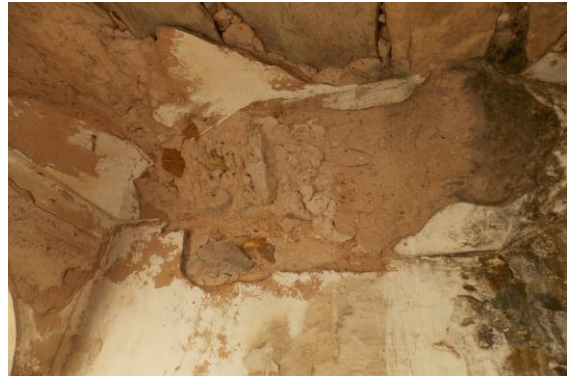
Photo 333

Damaged Portion on Roof All Wall of Varanda (Outer Side) of First Floor

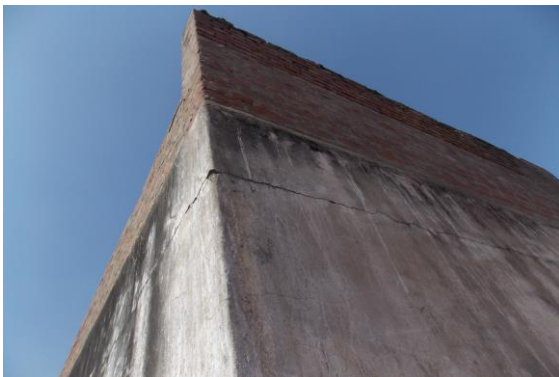
Photo 334

Damaged Portion on Roof All Wall of Varanda (Outer Side) of First Floor

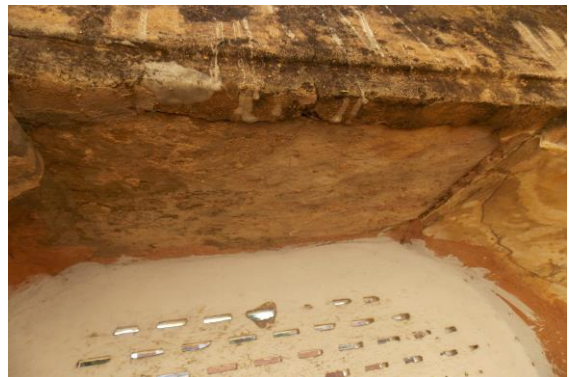
Photo 335

Damaged Portion on Roof All Wall of Varanda (Outer Side) of First Floor

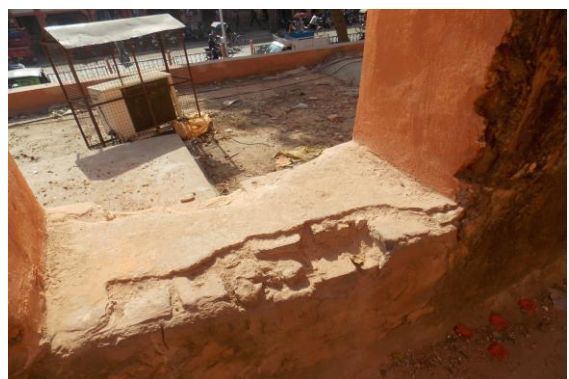
Photo 337

Damaged Portion on Roof All Wall of Varanda (Outer Side) of First Floor

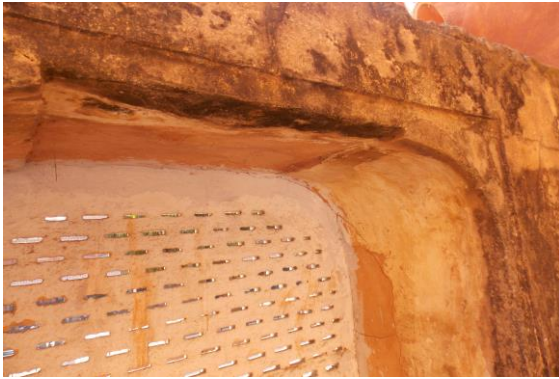
Photo 338

Damaged Portion on Roof All Wall of Varanda (Outer Side) of First Floor

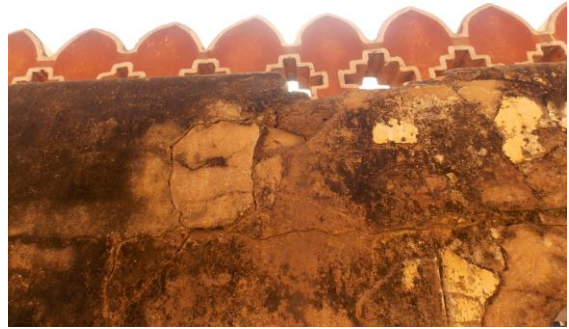
Photo 339

Damaged Portion on Roof All Wall of Varanda (Outer Side) of First Floor

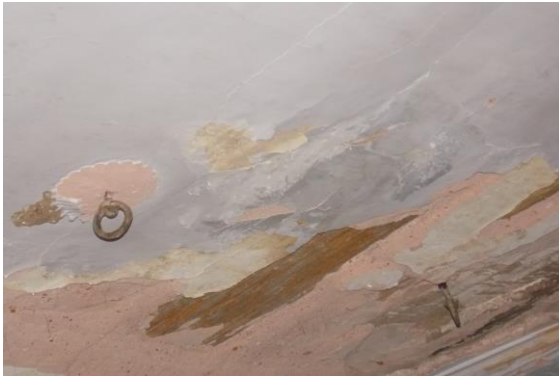
Photo 344

Damaged Portion on Roof of Room No. 1 of Second Floor

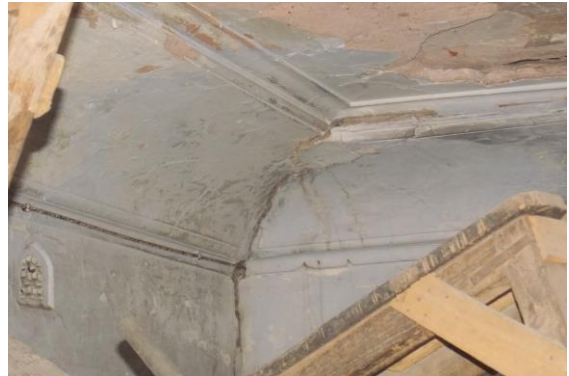
Photo 345

Damaged Portion on Wall No. 4 & Roof of Room No. 1 of Second Floor

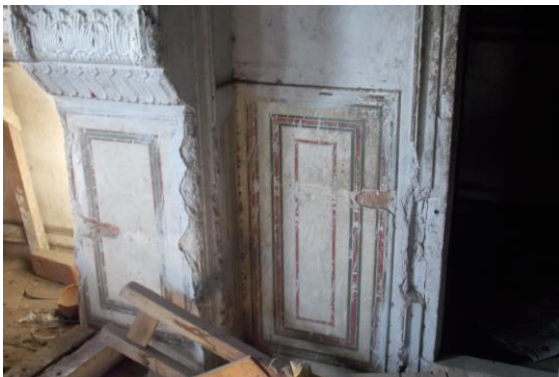
Photo 346

Peeling of Plaster on Wall No. 4 of Room No. 1 of Second Floor

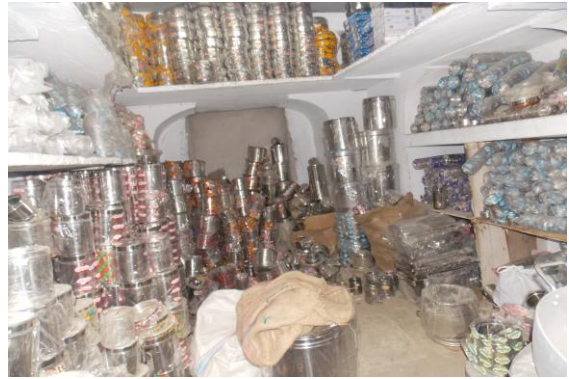
Photo 356

All Wall of Room No. 9 of Ground Floor Covered With Materials

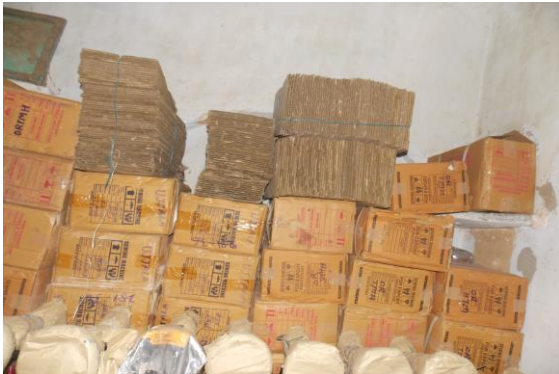
Photo 357

All Wall of Room No. 10 of Ground Floor Covered With Materials

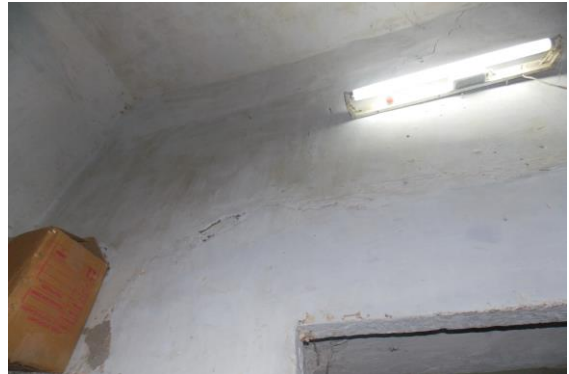
Photo 358

Wall No. 4 of Room No. 11 of Ground Floor Covered With Materials

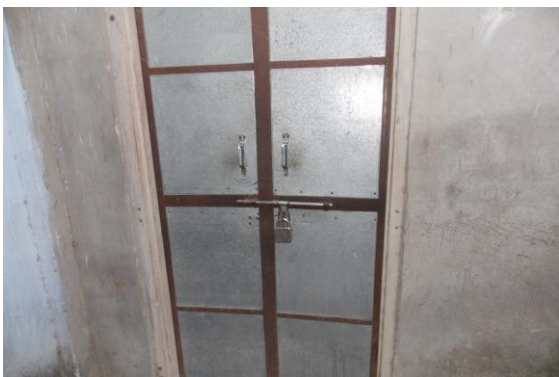
Photo 359

Wall No. 2 of Room No. 11 of Ground Floor Covered With Materials

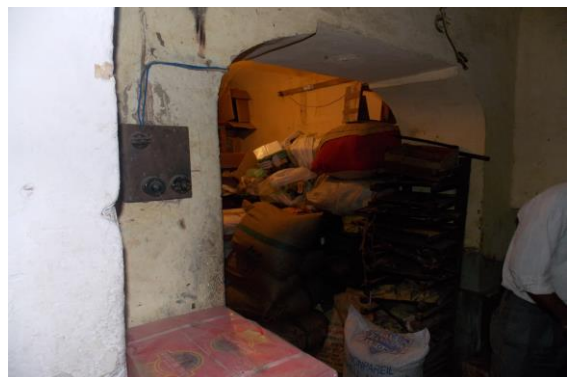
Photo 360

Room No. 13 of Ground Floor Locked

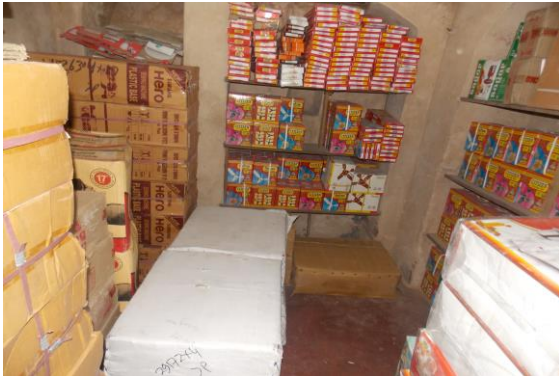
Photo 361

All Wall of Room No. 15 of Ground Floor Covered With Materials

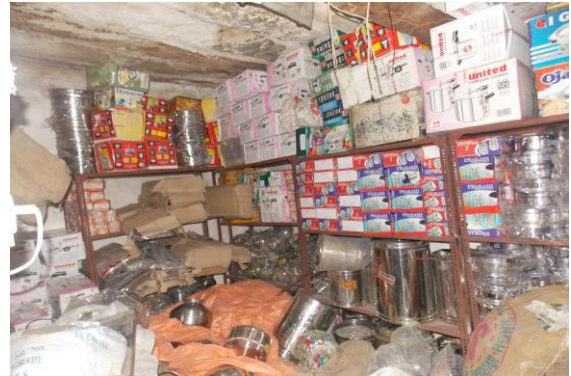
Photo 362
All Wall of Ground Floor Covered With Materials

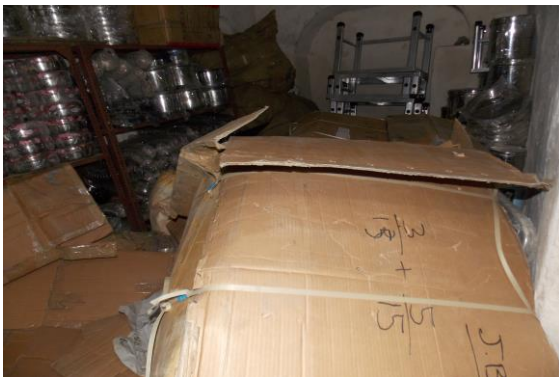
Photo 363
Wall No. 1 & 4 of Room No. 18 of Ground Floor Covered With Materials

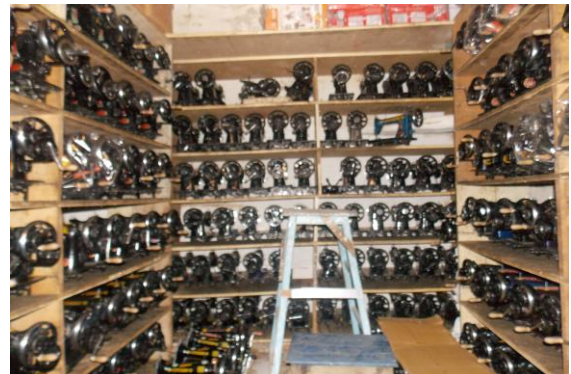
Photo 364
Floor of Room No. 18 of Ground Floor Covered With Materials

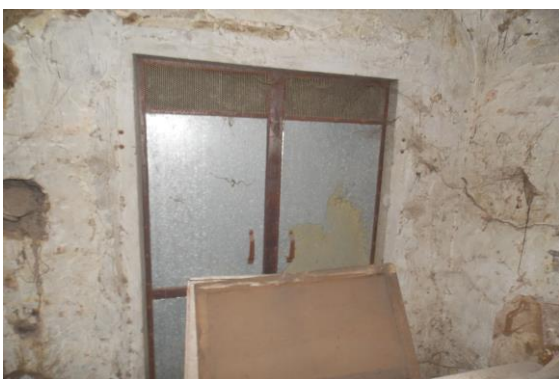
Photo 365
All Wall of Room No. 22 of Ground Floor Covered With Materials

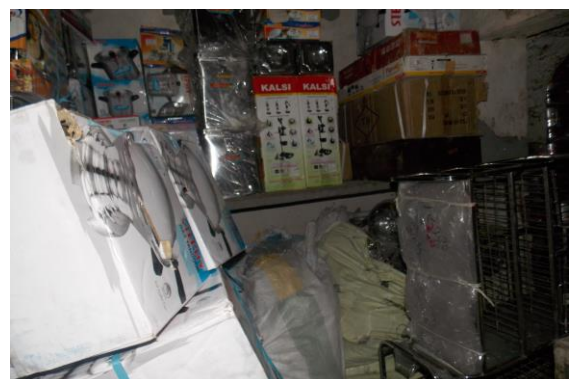
Photo 366
Room No. 23 of Ground Floor Locked

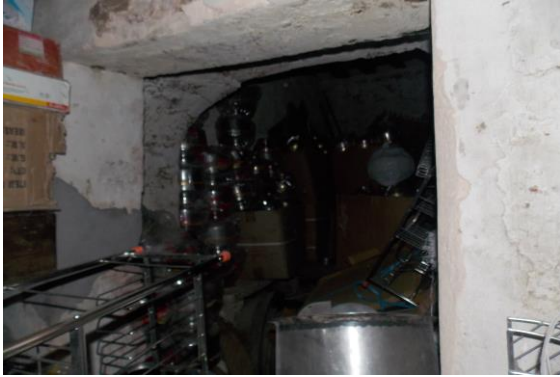
Photo 367
All wall of Room No. 24 of Ground Floor Covered With Materials

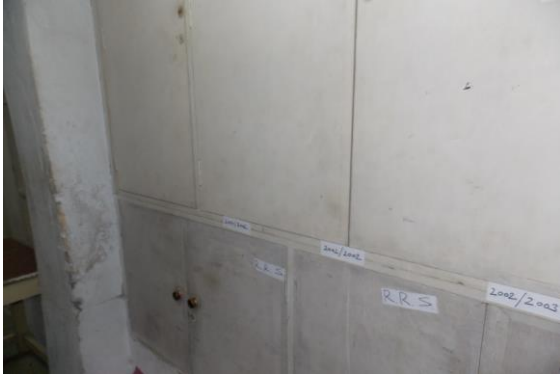
Photo 369
Wall No. 1 of Room No. 26 of Ground Floor Covered With Almira

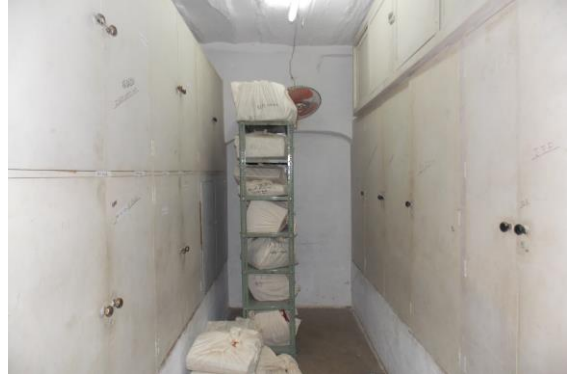
Photo 370
Wall No. 2 of Room No. 26 of Ground Floor Covered With Almira

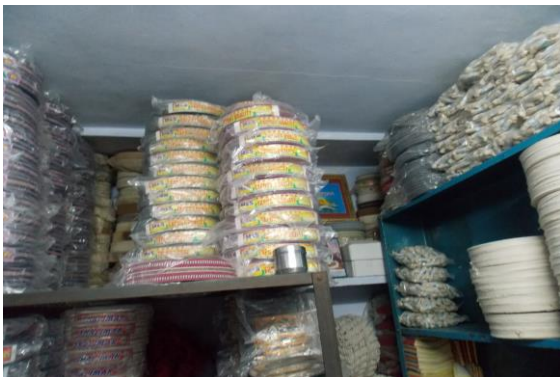
Photo 371
Wall No. 1 & 2 of Room No. 27 of Ground Floor Covered With Almira

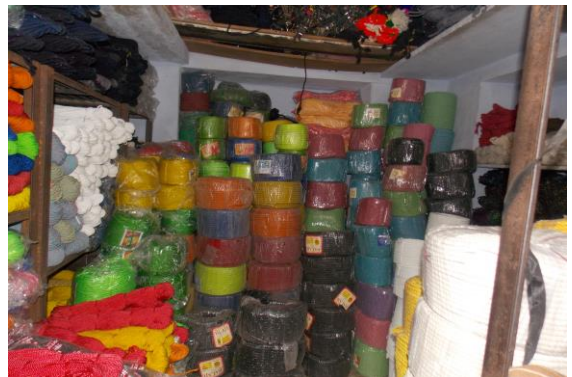
Photo 372
All wall of Room No. 30 of Ground Floor Covered With Materials

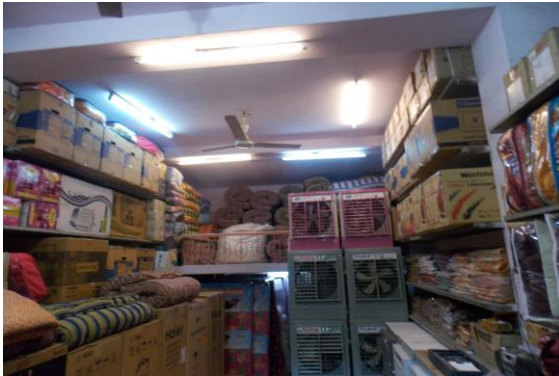
Photo 373
All wall of Room No. 31 of Ground Floor Covered With Materials

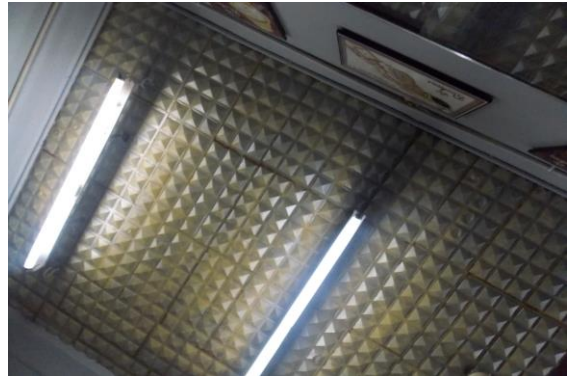
Photo 374
All Wall of Room No. 32 of Ground Floor Covered With Materials

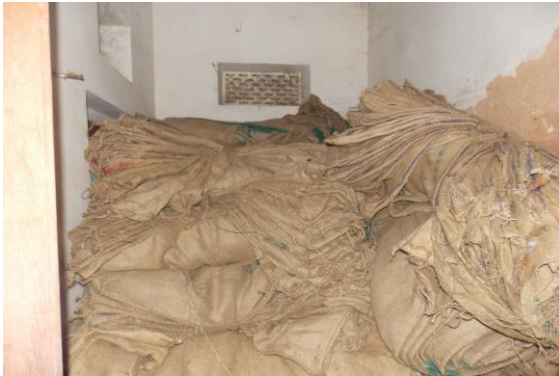
Photo 379
Store 1 of Ground Floor Locked

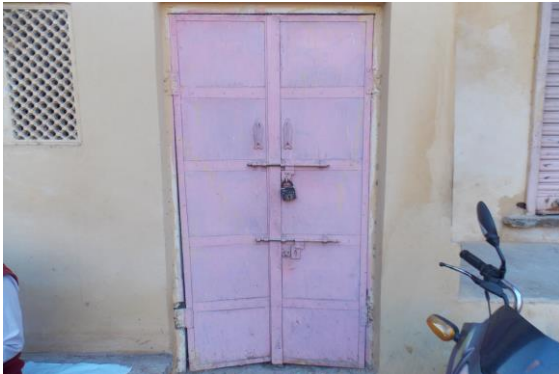
Photo 381

Room No. 46 of Ground Floor Locked

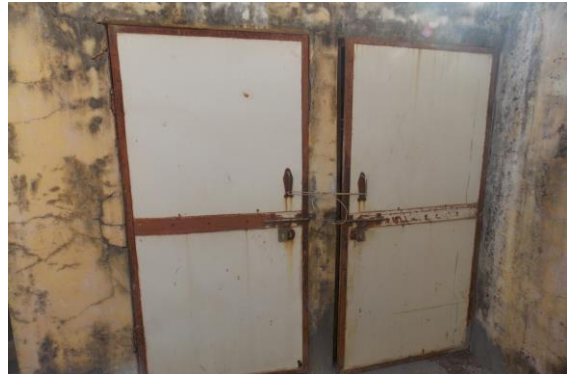
Photo 382

Shop 2 of Ground Floor Locked

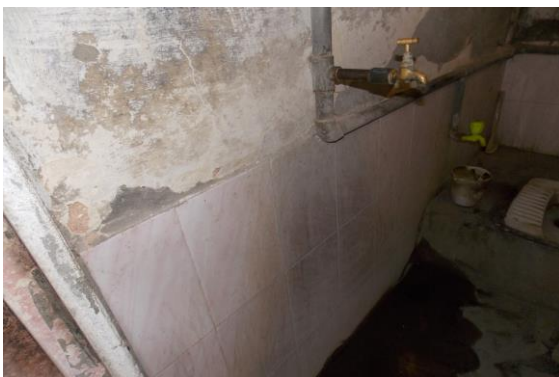
Photo 383

Toilet No. 1&2 of First Floor Locked

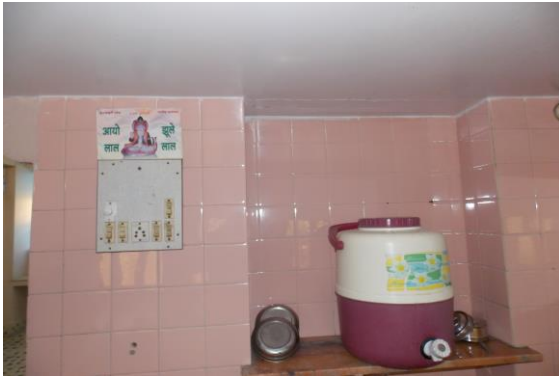
Photo 398

Wall No. 3 of Room No. 28 of First Floor Covered With Tiles

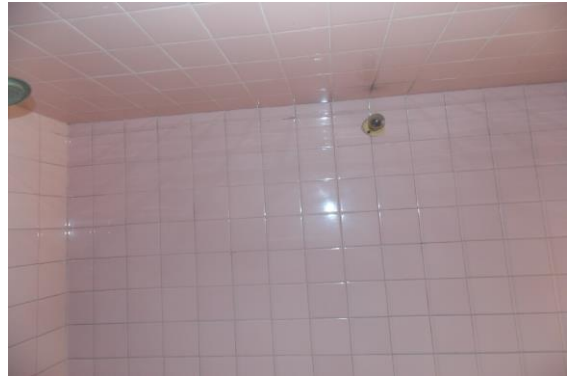
Photo 399

All Wall of Toilet No. 10 of First Floor Covered With Tiles

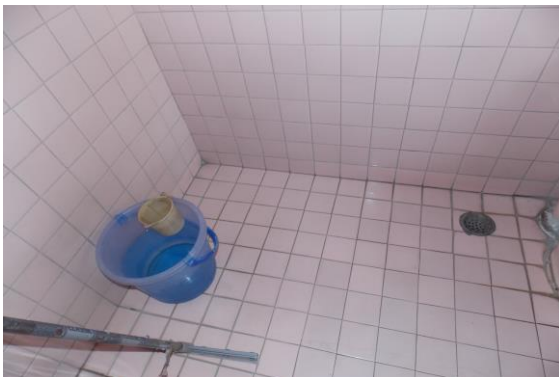
Photo 400

All Wall of Toilet No. 10 of First Floor Covered With Tiles

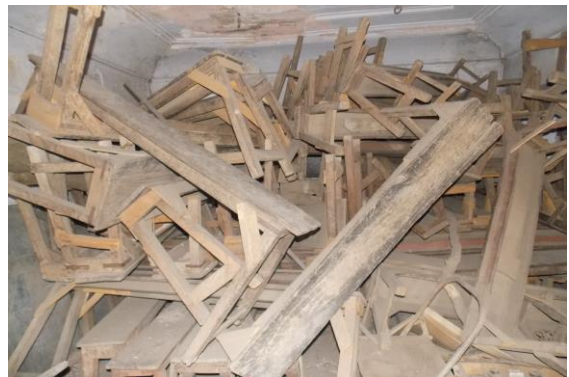
Photo 401

Wall No. 2, 3 & 4 of Room No. 1 of Second Floor Covered With Materials

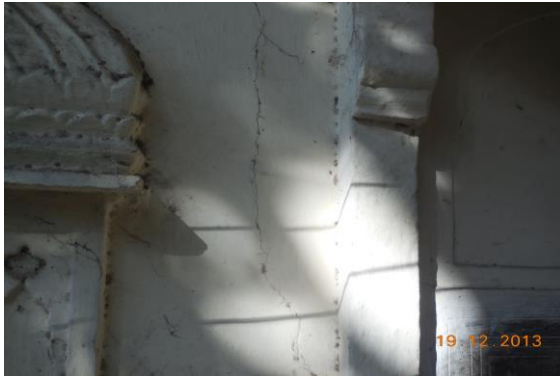
Photo 7

Inclined Crack on Wall No. External Wall of Temple Brij Bihari Ji, Ground Floor, Approx. Width = 0.35mm, Approx. Length = 2m. Distance from Left Tomb = 0m, Height from Floor = 0.3m.

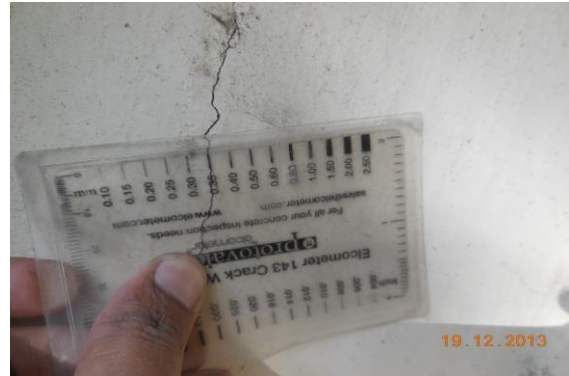
Photo 7A

Inclined Crack on Wall No. External Wall of Temple Brij Bihari Ji, Ground Floor, Approx. Width = 0.35mm, Approx. Length = 2m. Distance from Left Tomb = 0m, Height from Floor = 0.3m.

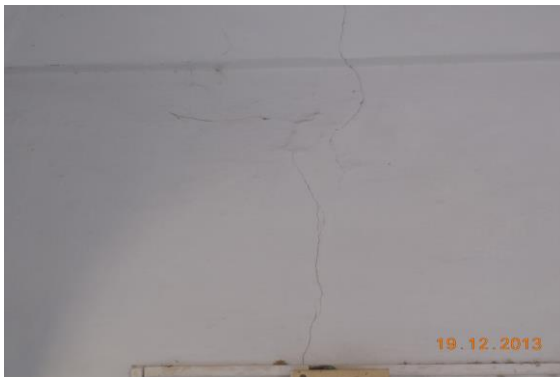
Photo 8

Inclined Crack on Wall No. 3 of Varanda No.1, Ground Floor Approx. Width = 0.3mm, Approx. Length = 2.7m. Distance from Wall No.1 = 2.1m, Height from Floor = 0.7m.

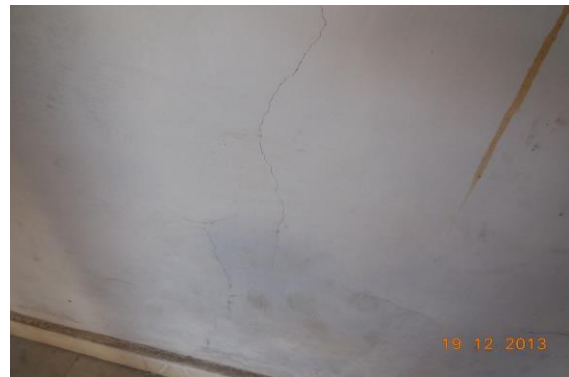
Photo 8A

Inclined Crack on Wall No. 3 of Varanda No.1, Ground Floor Approx. Width = 0.3mm, Approx. Length = 2.7m. Distance from Wall No.1 = 2.1m, Height from Floor = 0.7m.

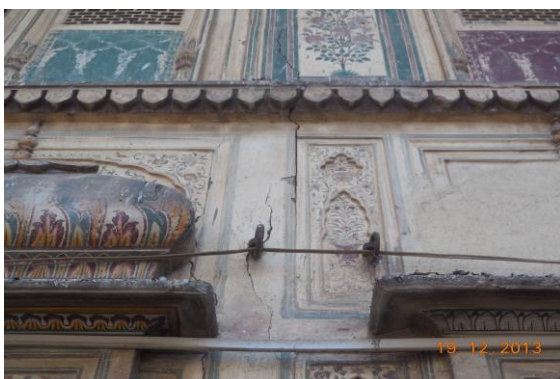
Photo 9

Inclined Crack Open to Sky at Ground Floor, Approx. Width = 0.8mm, Approx. Length = 4m. Distance from Wall No.2 = 8m, Height from Floor = 1.3m.

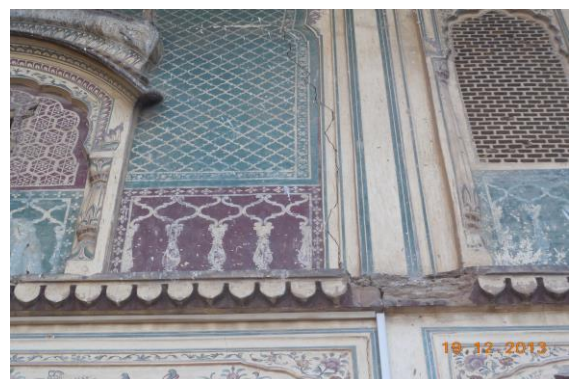
Photo 10

Inclined Crack on Wall No. 3 of Open Area, Ground Floor, Approx. Width = 4mm, Approx. Length = 3.5m. Distance from Wall No.2 = 6m, Height from Floor = 3m.

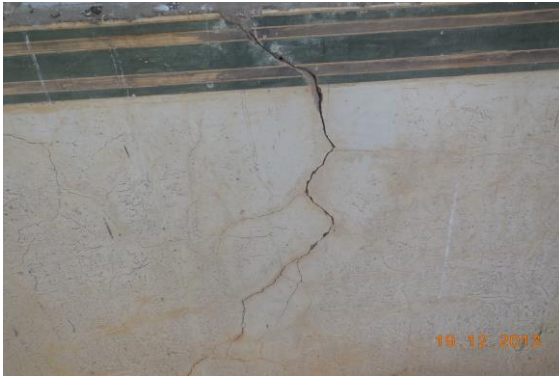
Photo 11

Inclined Crack on Wall No. 3 of Open Area, Ground Floor, Approx. Width = 2mm, Approx. Length = 1.3m., Distance from Wall No.2 = 2m, Height from Floor = 0.2m.

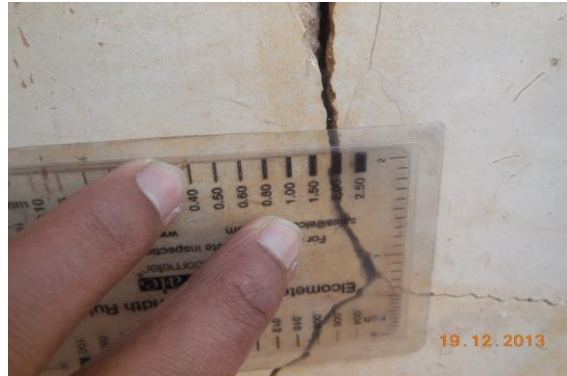
Photo 11A

Inclined Crack on Wall No. 3 of Open Area, Ground Floor, Approx. Width = 2mm, Approx. Length = 1.3m., Distance from Wall No.2 = 2m, Height from Floor = 0.2m.,

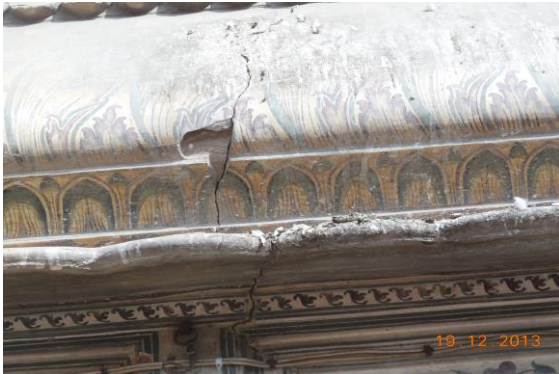
Photo 12

Inclined Crack on Wall No. 2 of Open Area, Ground Floor, Approx. Width = 2mm, Approx. Length = 1.5m., Distance from Wall No.3 = 8m, Height from Floor = 2m.,

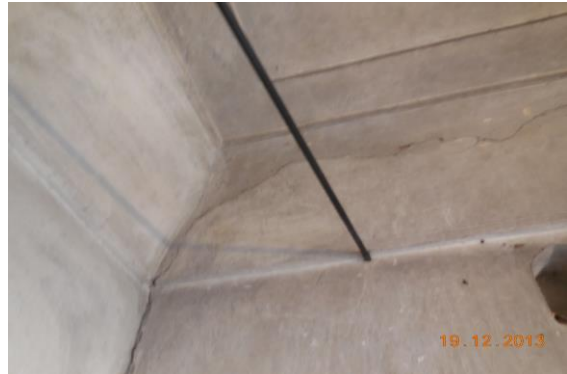
Photo 13

Inclined Crack on Wall No. 4 & Roof of Room No. 5, Ground Floor, Approx. Width = 1mm, Approx. Length = 5m. Distance from = m, Height from Floor = 0m.

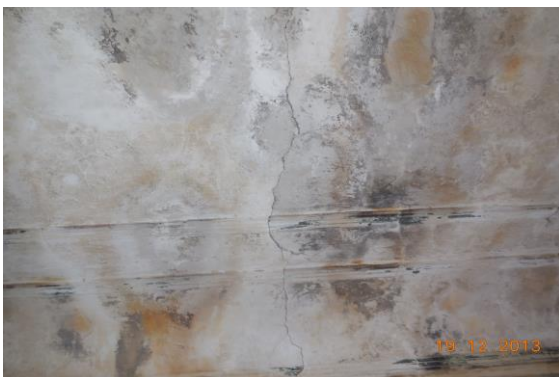
Photo 14

Horizontal Crack on Roof of Varanda No.3, Ground Floor, Approx. Width = 0.8mm, Approx. Length = 1.7m., Distance from Wall No.3 = 1.9m, Height from Floor = 3m.

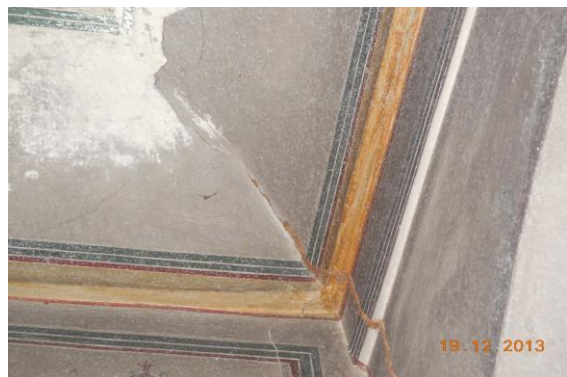
Photo 15

Inclined Crack on Wall No. 1 & Roof of Varanda No.3, Ground Floor, Approx. Width = 0.6mm, Approx. Length = 2.5m., Distance from Wall no.3 = 4m, Height from Floor = 1.5m.

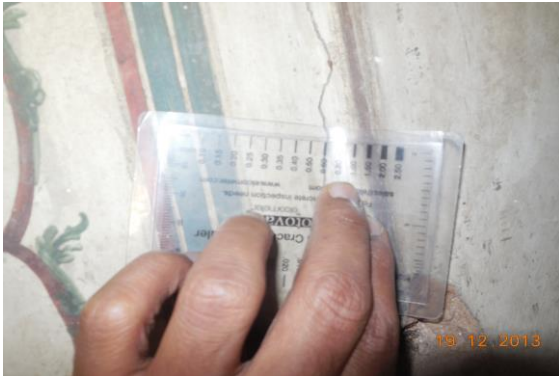
Photo 15A

Inclined Crack on Wall No. 1 & Roof of Varanda No.3, Ground Floor, Approx. Width = 0.6mm, Approx. Length = 2.5m. Distance from Wall no.3 = 4m, Height from Floor = 1.5m.

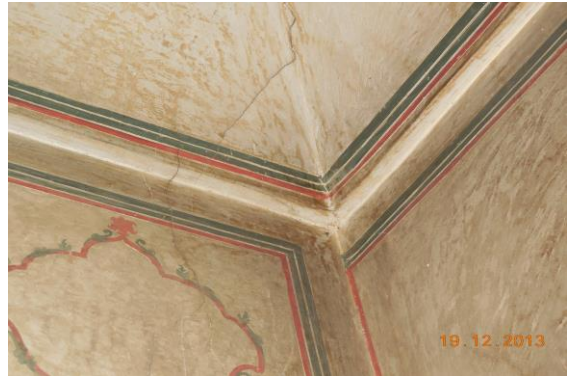
Photo 16

Inclined Crack on Wall No. 7 & Roof of Varanda No.3, Ground Floor, Approx. Width = 0.6mm, Approx. Length = 3.5m. Distance from Wall No.1 = 5.5m, Height from Floor = 1.5m.

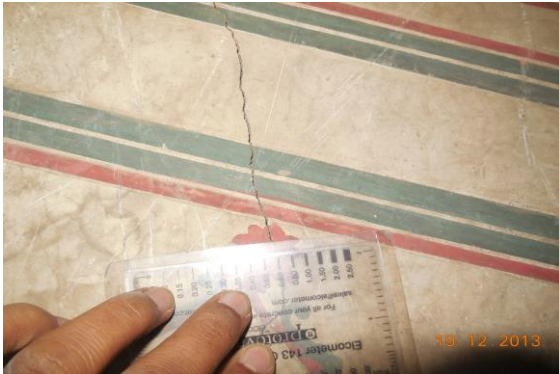
Photo 16A

Inclined Crack on Wall No. 7 & Roof of Varanda No.3, Ground Floor, Approx. Width = 0.6mm, Approx. Length = 3.5m. Distance from Wall No.1 = 5.5m, Height from Floor = 1.5m.

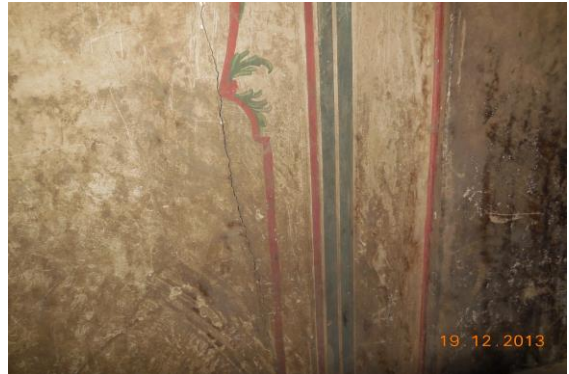
Photo 17

Inclined Crack on Wall No. 7 & Roof of Varanda No.3, Ground Floor, Approx. Width = 0.4mm, Approx. Length = 0.8m. Distance from Wall No.1 = 5.4m, Height from Floor = 1m.

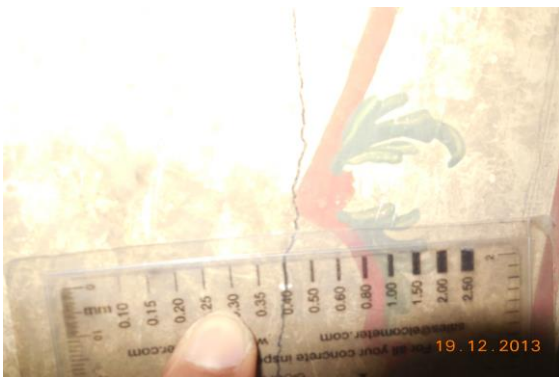
Photo 17A

Inclined Crack on Wall No. 7 & Roof of Varanda No.3, Ground Floor, Approx. Width = 0.4mm, Approx. Length = 0.8m. Distance from Wall No.1 = 5.4m, Height from Floor = 1m.

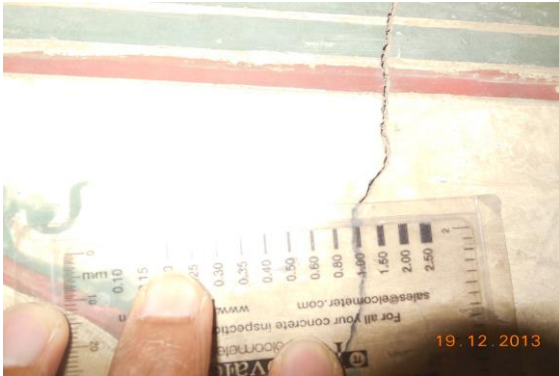
Photo 18A

Inclined Crack on Wall No. 4 & Roof of Varanda No.3, Ground Floor, Approx. Width = 1mm, Approx. Length = 4m.
Distance from Wall No.1 = 6.5m, Height from Floor = 1.3m.

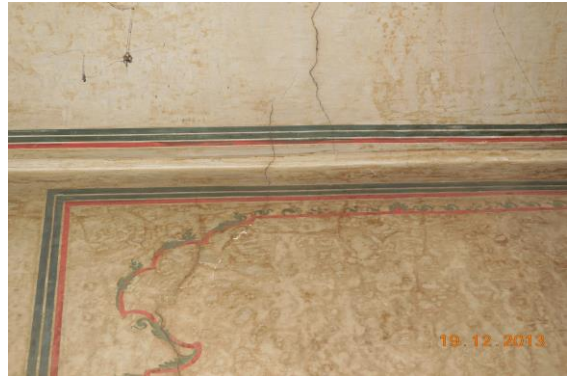
Photo 19

Inclined Crack on Wall No. 7 & Roof of Varanda No.3, Ground Floor, Approx. Width = 0.5mm, Approx. Length = 3.5m.
Distance from Wall No.1 = 9m, Height from Floor = 1.3m.

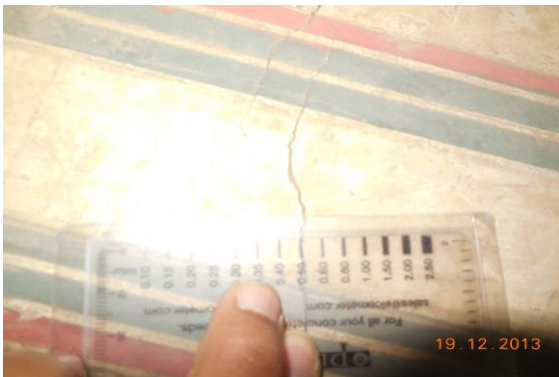
Photo 19A

Inclined Crack on Wall No. 7 & Roof of Varanda No.3, Ground Floor, Approx. Width = 0.5mm, Approx. Length = 3.5m.
Distance from Wall No.1 = 9m, Height from Floor = 1.3m.

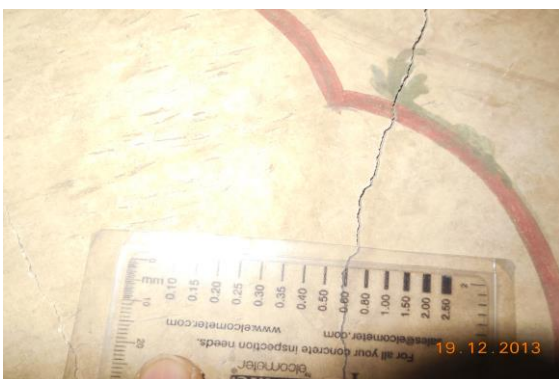
Photo 20A

Inclined Crack on Wall No. 4 & Roof of Varanda No.3, Ground Floor, Approx. Width = 0.6mm, Approx. Length = 4m.
Distance from Wall No.1 = 10m, Height from Floor = 1m.

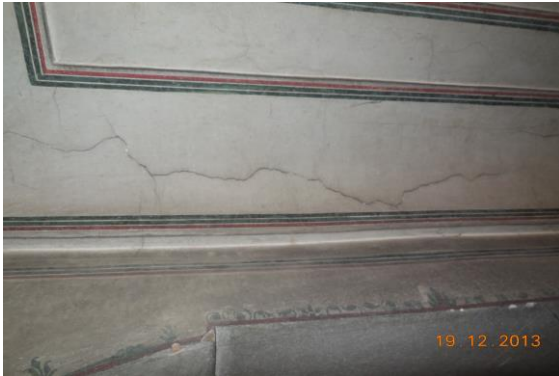
Photo 22

Inclined Crack on Roof of Varanda No.3, Ground Floor, Approx. Width = 1mm, Approx. Length = 2m.
Distance from Wall No.8 = 0m, Height from Floor = 2.5m.

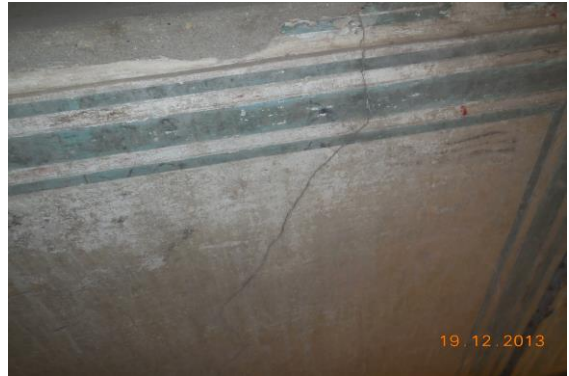
Photo 23

Inclined Crack on Wall No. 2 of Varanda No.3, Ground Floor, Approx. Width = 0.8mm, Approx. Length = 0.8m.
Distance from Wall No.3 = 4.8m, Height from Floor = 0.25m.

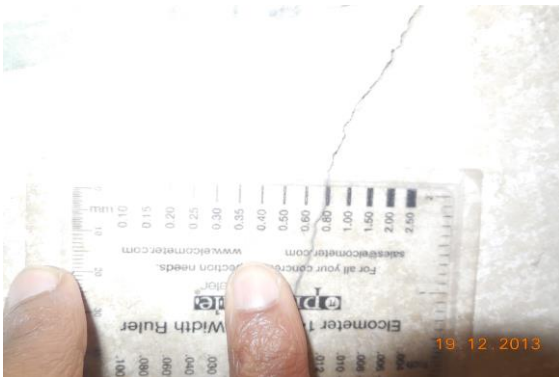
Photo 23A

Inclined Crack on Wall No. 2 of Varanda No.3, Ground Floor
Approx. Width = 0.8mm, Approx. Length = 0.8m.
Distance from Wall No.3 = 4.8m, Height from Floor = 0.25m.

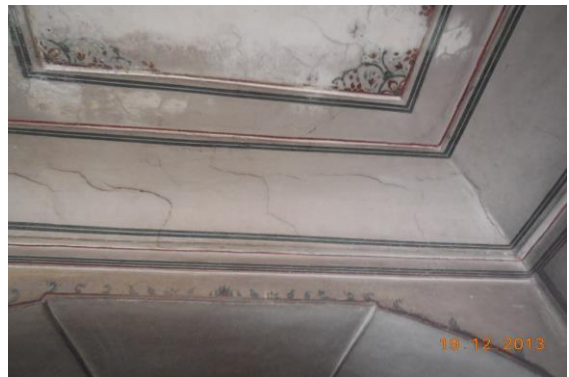
Photo 24

Inclined Crack on Roof of Varanda No.3, Ground Floor
Approx. Width = 2mm, Approx. Length = 2m.
Distance from Wall No.3 = 4m, Height from Floor = 2.5m.

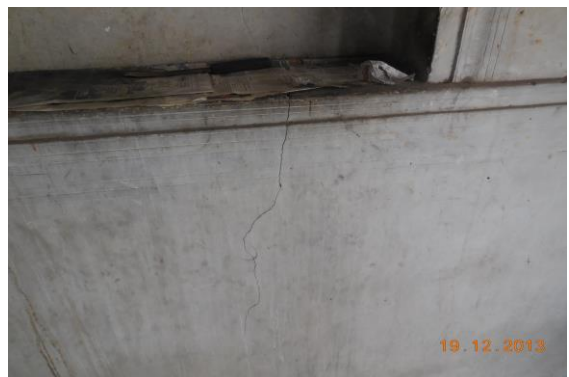
Photo 26

Inclined Crack on Wall No. 5 of Varanda No.3, Ground Floor, Approx. Width = 0.5mm, Approx. Length = 2m.
Distance from Wall No.1 = 4m, Height from Floor = 0m.

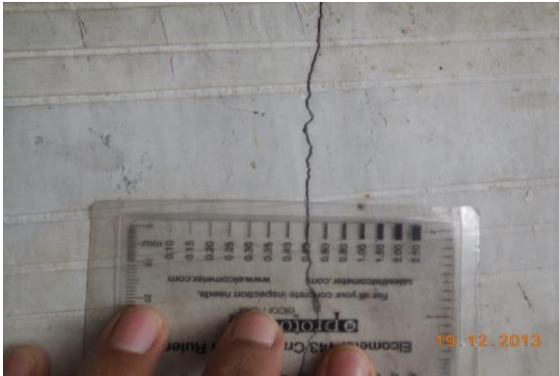
Photo 26A

Inclined Crack on Wall No. 5 of Varanda No.3, Ground Floor, Approx.
Width = 0.5mm, Approx. Length = 2m.
Distance from Wall No.1 = 4m, Height from Floor = 0m.

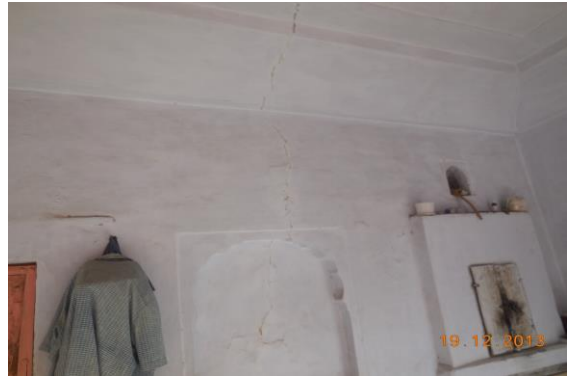
Photo 27

Inclined Crack on Wall No. 4 & Roof of Varanda No.4, Ground Floor, Approx. Width = 2.5mm, Approx. Length = 4.5m.
Distance from Wall No.2 = 2m, Height from Floor = 0.25m.
