Pre Building Condition Survey Report

Name and Address of Structure :	Choti Chopar to Badi Chopar (UP Line)
---------------------------------	---------------------------------------

Name of the Project	Contract JMRC-UG1B “Design and Construction of Tunnel between Chandpole and Badi Chouper and reverse line by Shield TBM, Underground Metro Stations at Choti Chouper and Badi Chouper by Cut and Cover Methods on East West Corridor of Jaipur Metro Rail Corporation Limited .”	
Owner :

Shoping Complex - Shop No. 169-188
Tripolia Bazar
Jaipur
Unique ID: CC BC UP 0001

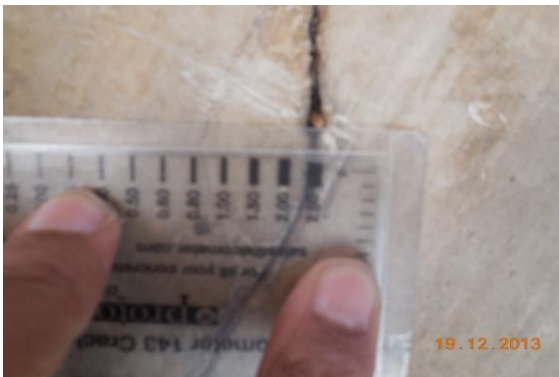
Photo 27A

Inclined Crack on Wall No. 4 & Roof of Varanda No.4, Ground Floor, Approx. Width = 2.5mm, Approx. Length = 4.5m.
Distance from Wall No.2 = 2m, Height from Floor = 0.25m.

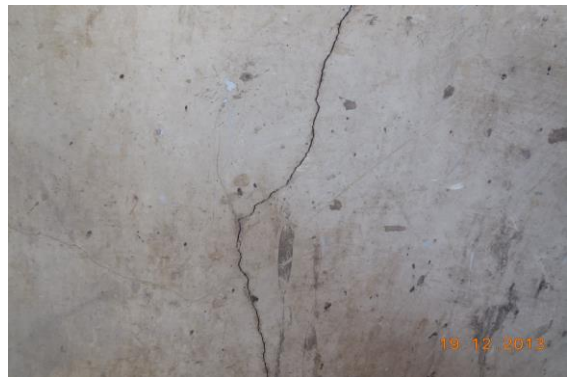
Photo 28

Inclined Crack on Wall No. 4 of Varanda No.4, Ground Floor, Approx. Width = 1mm, Approx. Length = 1.1m.
Distance from Wall No.2 = 0.7m, Height from Floor = 0.05m.

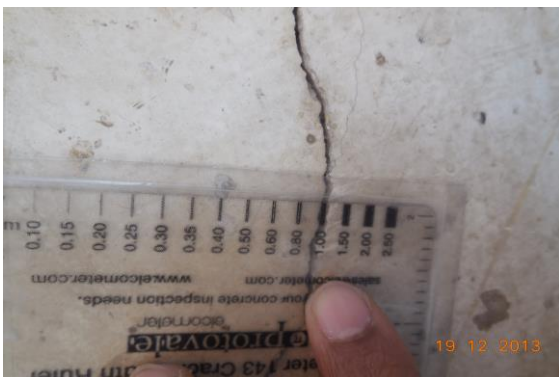
Photo 28A

Inclined Crack on Wall No. 4 of Varanda No.4, Ground Floor, Approx. Width = 1mm, Approx. Length = 1.1m.
Distance from Wall No.2 = 0.7m, Height from Floor = 0.05m.

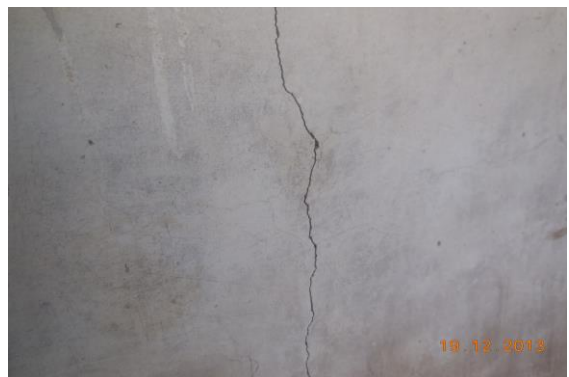
Photo 29

Inclined Crack on Wall No. 4 of Varanda No.2, Ground Floor, Approx. Width = 0.5mm, Approx. Length = 1m.
Distance from Wall No.2 = 2.5m, Height from Floor = 0.05m.

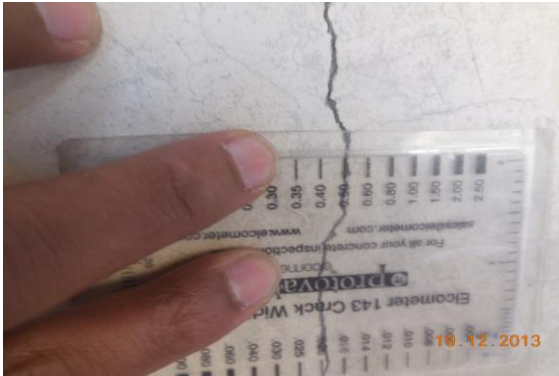
Photo 29A

Inclined Crack on Wall No. 4 of Varanda No.2, Ground Floor, Approx.
Width = 0.5mm, Approx. Length = 1m.
Distance from Wall No.2 = 2.5m, Height from Floor = 0.05m.

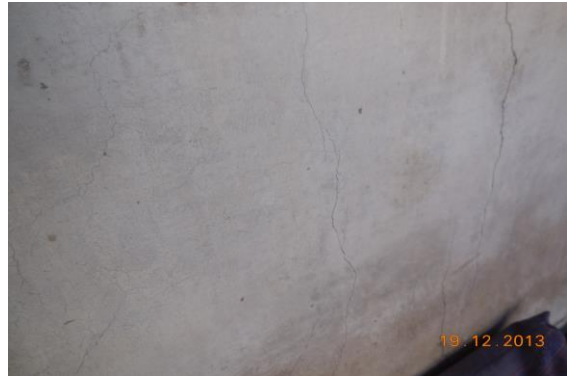
Photo 29A

Inclined Crack on Wall No. 4 of Varanda No.2, Ground Floor, Approx.
Width = 0.5mm, Approx. Length = 1m.
Distance from Wall No.2 = 2.5m, Height from Floor = 0.05m.

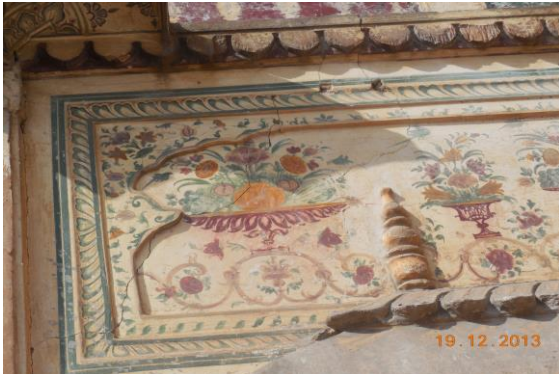
Photo 30

Inclined Crack on Wall No. 4 of Open Sky, Ground Floor, Approx. Width
= 1.5mm, Approx. Length = 3.5m.
Distance from Wall No.2 = 6m, Height from Floor = 1.28m.

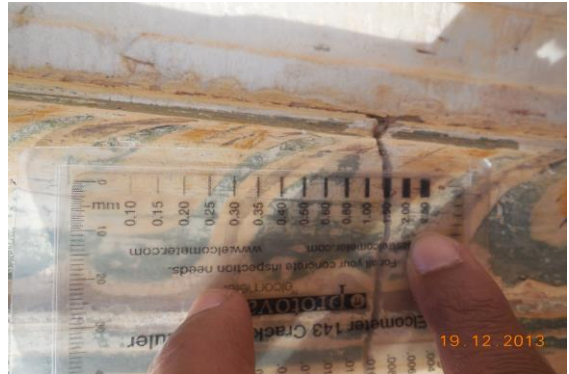
Photo 30A

Inclined Crack on Wall No. 4 of Open Sky, Ground Floor, Approx. Width
= 1.5mm, Approx. Length = 3.5m.
Distance from Wall No.2 = 6m, Height from Floor = 1.28m.

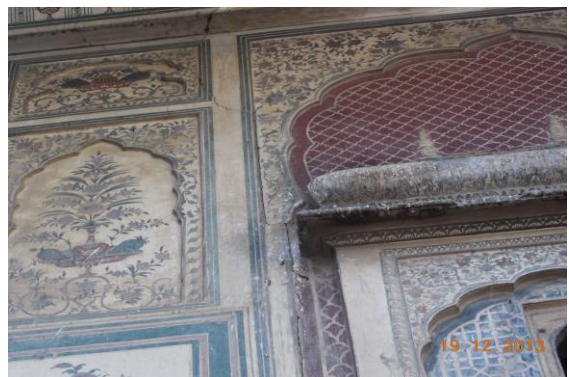
Photo 32

Inclined Crack on of Open Sky, Ground Floor, Approx. Width = 1.5mm,
Approx. Length = 2.8m.
Distance from Wall No.3 = 6m, Height from Floor = 3m.

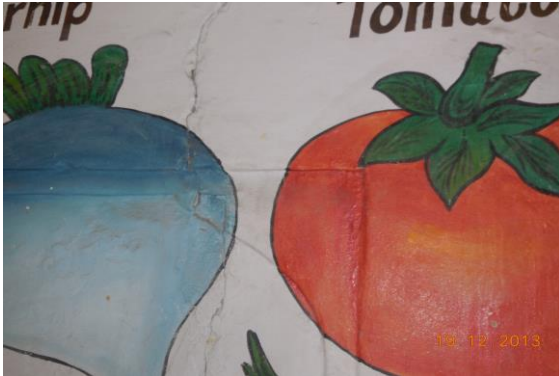
Photo 33

Inclined Crack on Wall No. 2 & Roof of Room No. 2, School, First Floor, Approx. Width = 3mm, Approx. Length = 2m.
Distance from = m, Height from Floor = m.

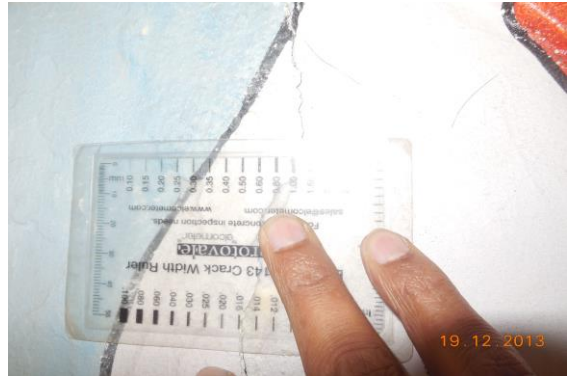
Photo 33A

Inclined Crack on Wall No. 2 & Roof of Room No. 2, School, First Floor, Approx. Width = 3mm, Approx. Length = 2m.
Distance from = m, Height from Floor = m.

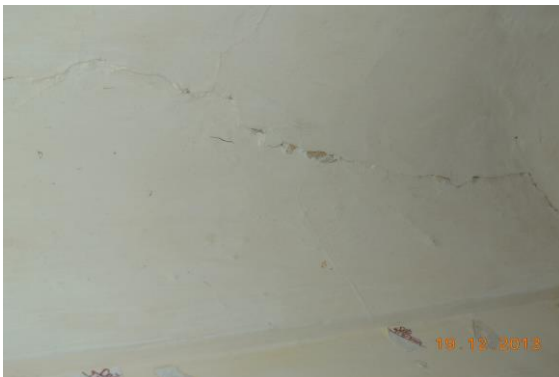
Photo 34

Inclined Crack on Roof of Room No. 3, School, First Floor, Approx. Width = 0.5mm, Approx. Length = 1m.
Distance from = m, Height from Floor = m.

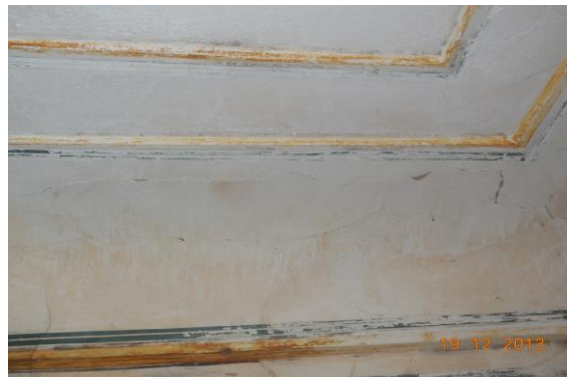
Photo 35

Inclined Crack on Roof of Gallery No.3, First Floor, Approx. Width = 1mm, Approx. Length = 2m.
Distance from Wall No.1 & 2 = 0m, Height from Floor = 2.4m.

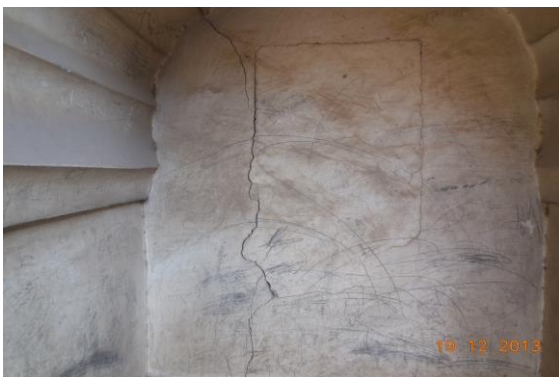
Photo 36

Inclined Crack on Wall No. 4 of Open Sky, First Floor, Approx. Width = 5mm, Approx. Length = 1.5m.
Distance from Wall No.2 = 0.5m, Height from Floor = 0.6m.

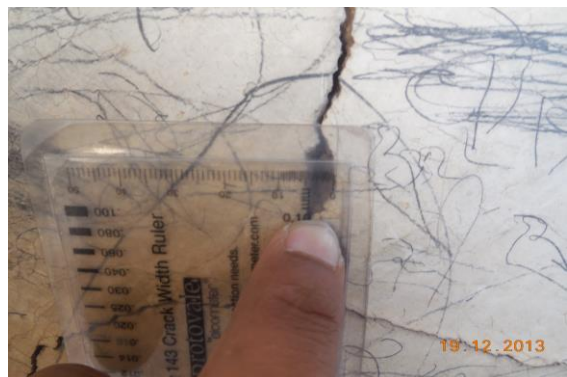
Photo 36A

Inclined Crack on Wall No. 4 of Open Sky, First Floor, Approx. Width = 5mm, Approx. Length = 1.5m.
Distance from Wall No.2 = 0.5m, Height from Floor = 0.6m.

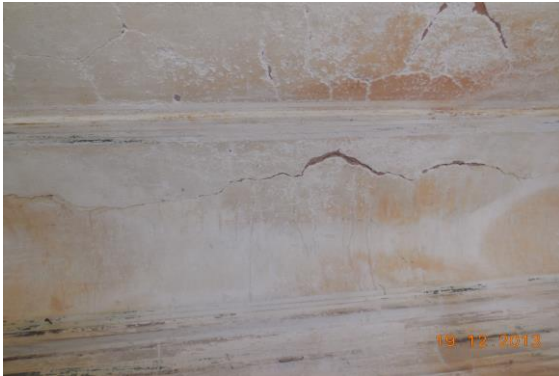
Photo 37

Inclined Crack on Roof of Varanda, First Floor, Approx. Width = 0.35mm, Approx. Length = 2.7m.
Distance from Wall No.1 & 2 = 0m, Height from Floor = 2.4m.

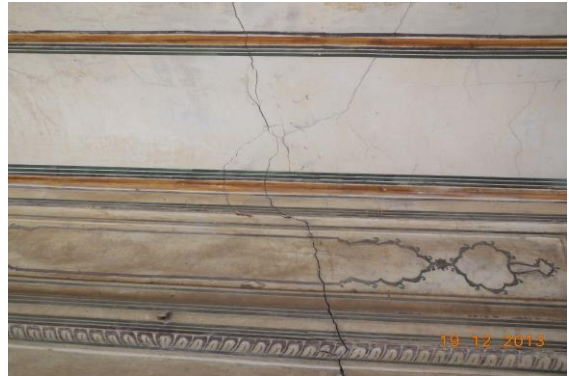
Photo 38

Inclined Crack on Wall No. 1 & Roof of Varanda, First Floor, Approx. Width = 2.5mm, Approx. Length = 3.6m.
Distance from Wall No.4 = 2.2m, Height from Floor = 1.8m.

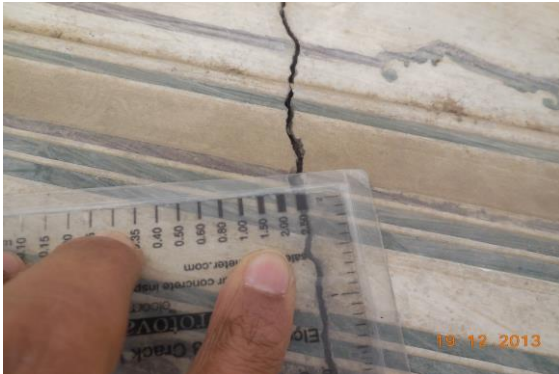
Photo 38A

Inclined Crack on Wall No. 1 & Roof of Varanda, First Floor, Approx. Width = 2.5mm, Approx. Length = 3.6m.
Distance from Wall No.4 = 2.2m, Height from Floor = 1.8m.

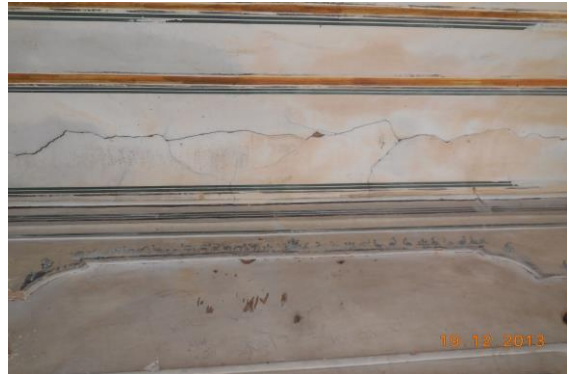
Photo 39

Inclined Crack on Roof of Varanda, First Floor, Approx. Width = 1.5mm, Approx. Length = 2.7m.
Distance from Wall No.4 = 0m, Height from Floor = 2.4m.

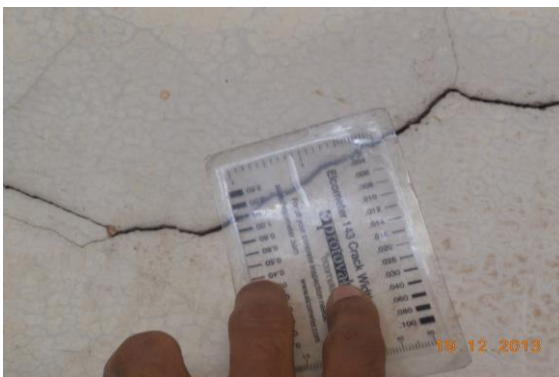
Photo 39A

Inclined Crack on Roof of Varanda, First Floor, Approx. Width = 1.5mm, Approx. Length = 2.7m.
Distance from Wall No.4 = 0m, Height from Floor = 2.4m.

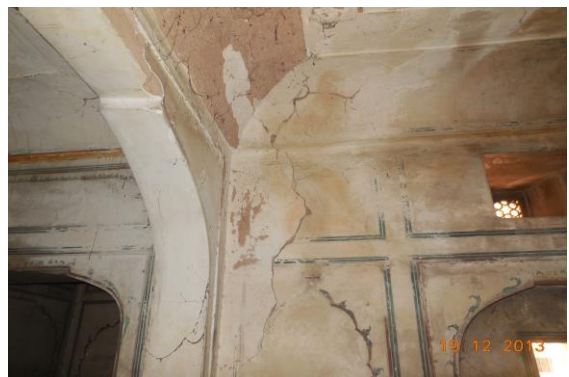
Photo 40

Inclined Crack on Wall No. 2 & Roof of Gallery No.2, First Floor, Approx. Width = 5mm, Approx. Length = 1.5m.
Distance from Wall No.2 = 8m, Height from Floor = 1.2m.

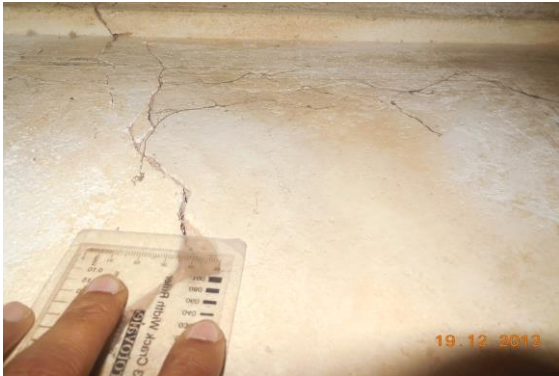
Photo 40A

Inclined Crack on Wall No. 2 & Roof of Gallery No.2, First Floor, Approx.
Width = 5mm, Approx. Length = 1.5m.
Distance from Wall No.2 = 8m, Height from Floor = 1.2m.

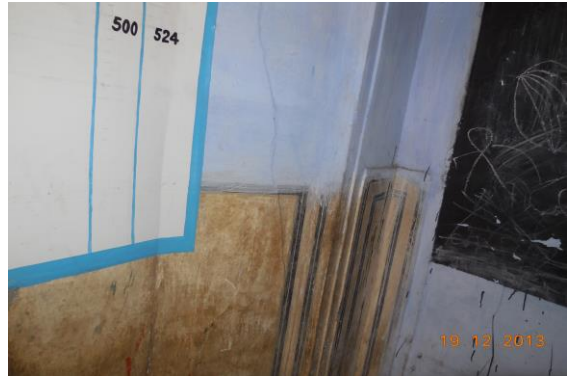
Photo 41

Inclined Crack on Wall No. 1 of Room No. 13, School, First Floor, Approx.
Width = 1.5mm, Approx. Length = 1.5m.
Distance from Wall No.4 = 0.3m, Height from Floor = 0m.

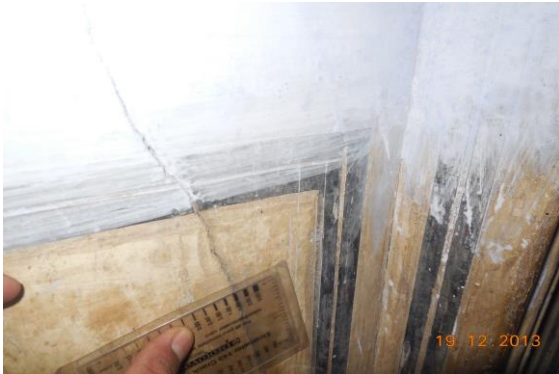
Photo 41A

Inclined Crack on Wall No. 1 of Room No. 13, School, First Floor, Approx.
Width = 1.5mm, Approx. Length = 1.5m.
Distance from Wall No.4 = 0.3m, Height from Floor = 0m.

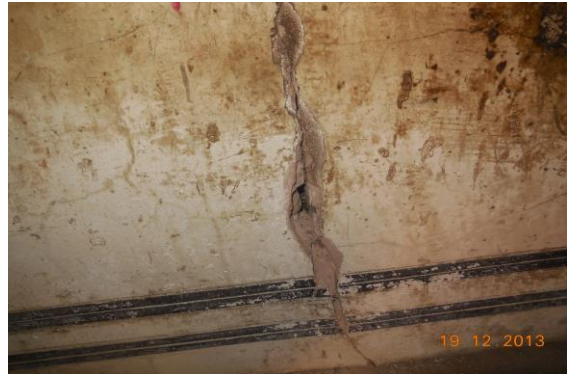
Photo 42

Vertical Crack on Wall No. 1 of Staircase Area, First Floor, Approx.
Width = 36mm, Approx. Length = 1m.
Distance from Wall No.4 = 4.5m, Height from Floor = 0m.

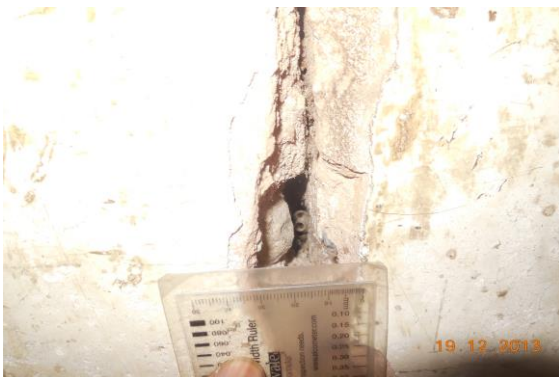
Photo 42A

Vertical Crack on Wall No. 1 of Staircase Area, First Floor, Approx.
Width = 36mm, Approx. Length = 1m.
Distance from Wall No.4 = 4.5m, Height from Floor = 0m.

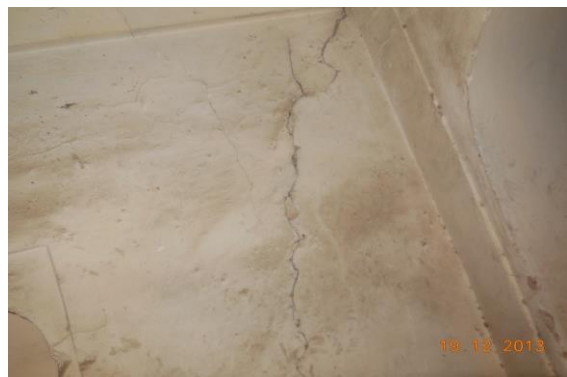
Photo 43

Inclined Crack on Wall No. 1 of Staircase Area, First Floor, Approx.
Width = 2mm, Approx. Length = 2.7m.
Distance from Wall No.4 = 3.5m, Height from Floor = 0m.

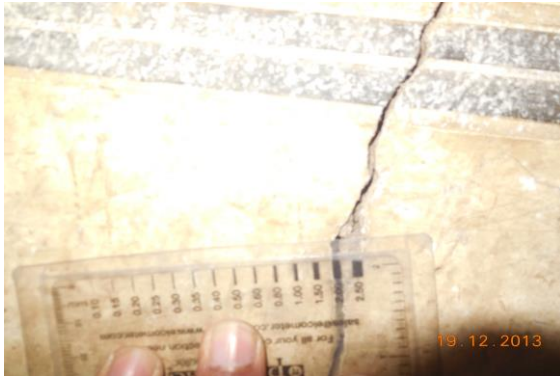
Photo 43A

Inclined Crack on Wall No. 1 of Staircase Area, First Floor, Approx.
Width = 2mm, Approx. Length = 2.7m.
Distance from Wall No.4 = 3.5m, Height from Floor = 0m.

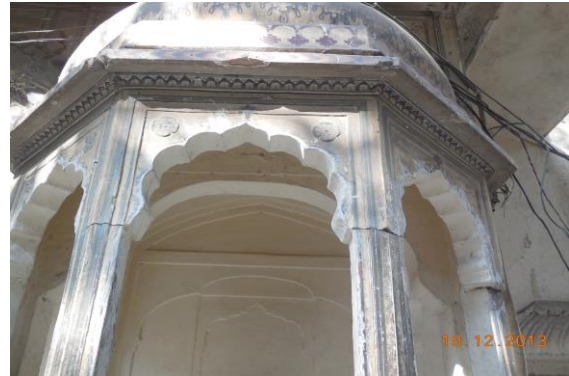
Photo 44

Damaged Portion on of Temple Brij Bihari Ji of Ground Floor,

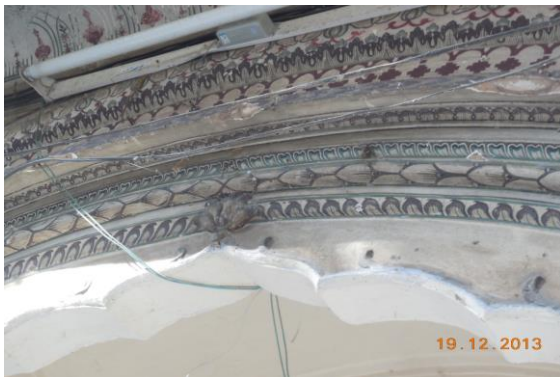
Photo 45

Peeling of Plaster on Main Gate of Temple Brij Bihari Ji of Ground Floor

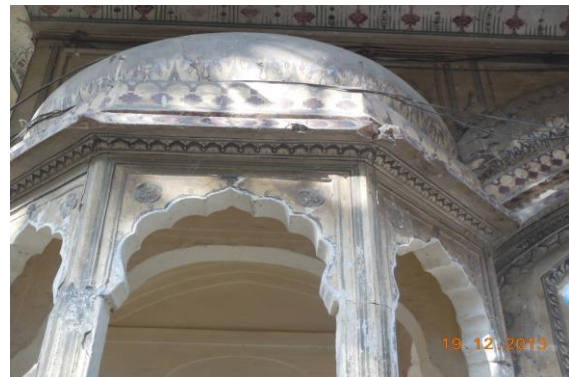
Photo 46

Damaged Portion on Left Handside Tomb of Temple Brij Bihari Ji of Ground Floor

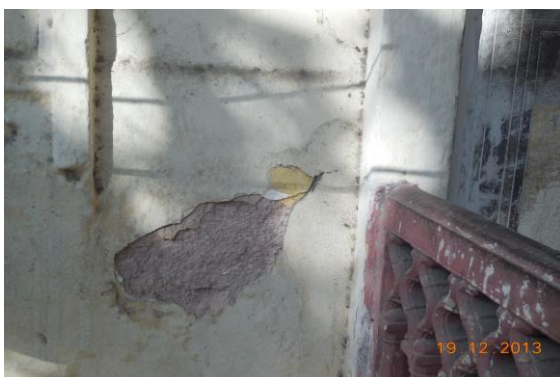
Photo 47

Peeling of Plaster on External Wall of Temple Brij Bihari Ji of Ground Floor

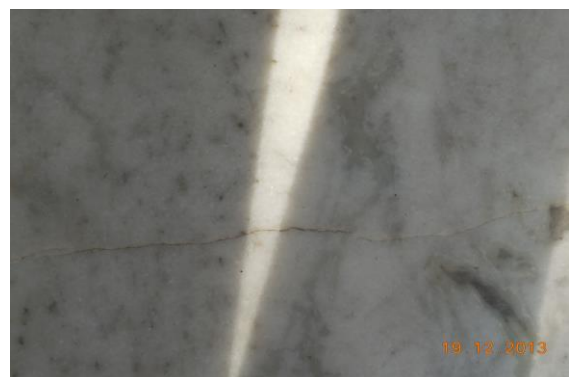
Photo 48

Damaged Portion on Entry Door of Temple Brij Bihari Ji of Ground Floor

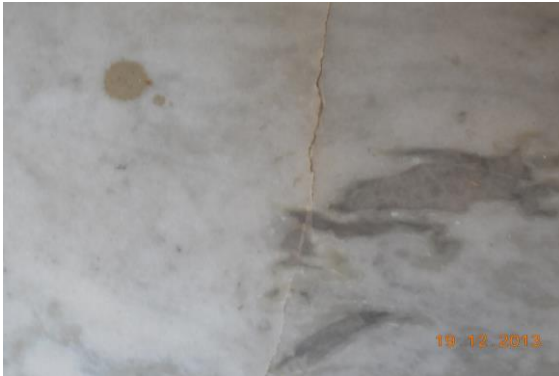
Photo 49

Damaged Portion on Entry Door of Temple Brij Bihari Ji of Ground Floor

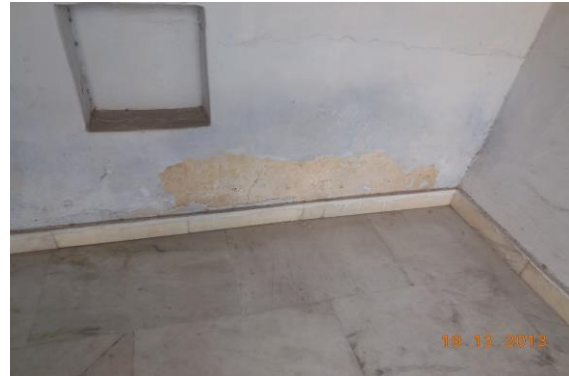
Photo 50

Peeling of Plaster on Varanda No.1 of Ground Floor

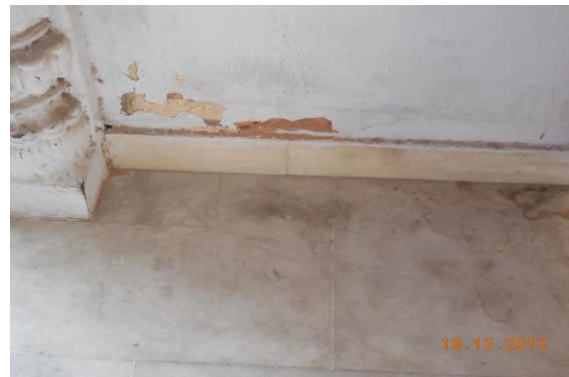
Photo 51

Plaster Crack on Wall No. 3 of Varanda No.1 of Ground Floor

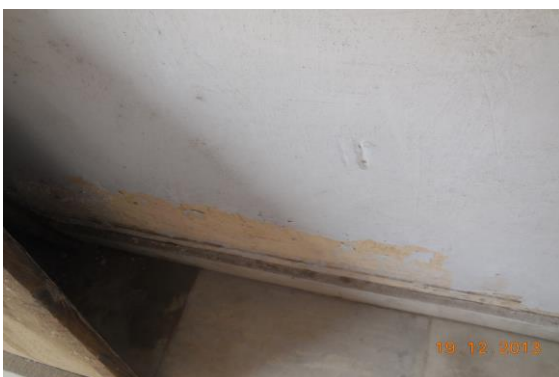
Photo 52

Peeling of Plaster on Wall No. 4 of Varanda No.1 of Ground Floor

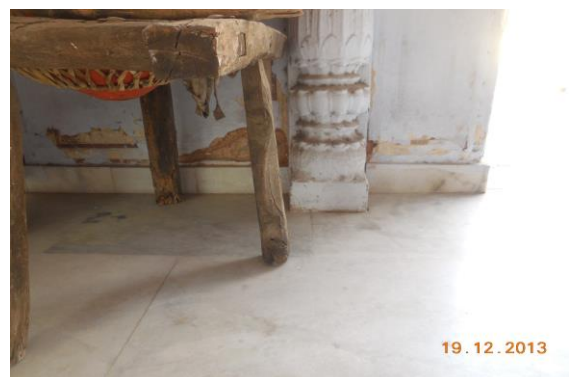
Photo 53

Dampness/Seepage on Wall No. 2 of Varanda No.1 of Ground Floor

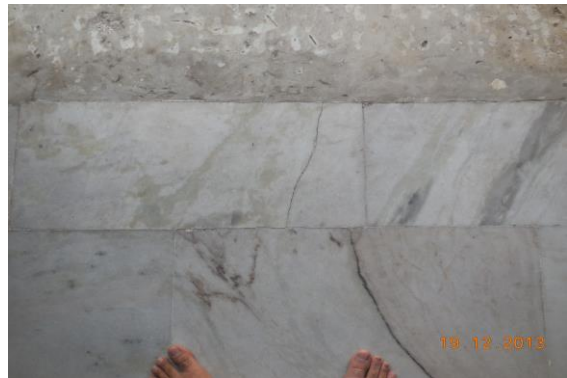
Photo 55
Damaged Portion on Floor of Varanda No.1 of Ground Floor

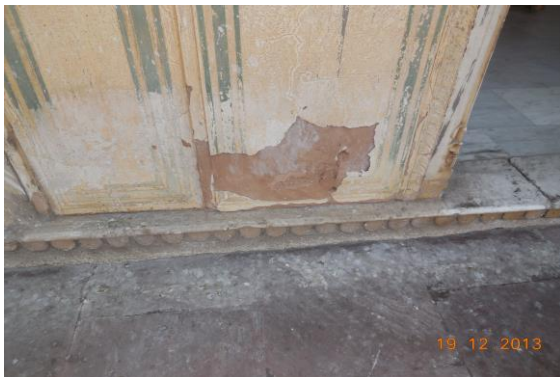
Photo 56
Damaged Portion on Floor of Varanda No.1 of Ground Floor

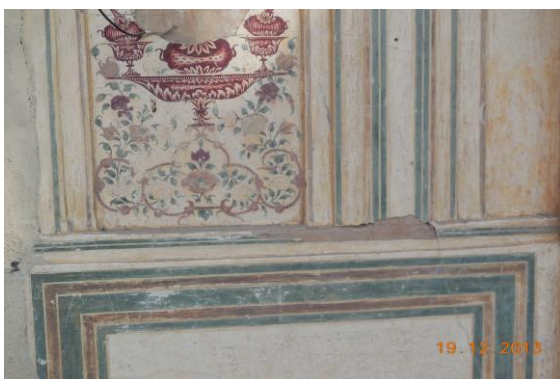
Photo 58
Damaged Portion on Wall No. 3 of Open Sky of Ground Floor

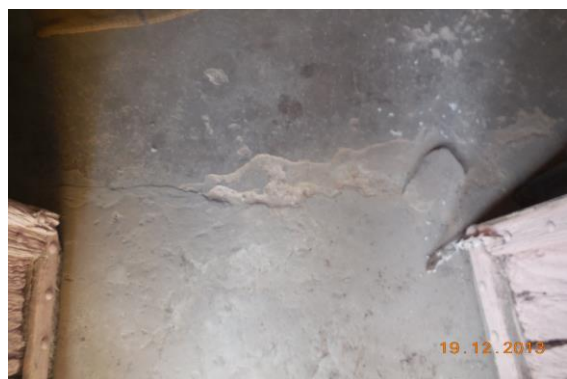
Photo 59
Peeling of Plaster on Wall No. 2 of Open Sky of Ground Floor

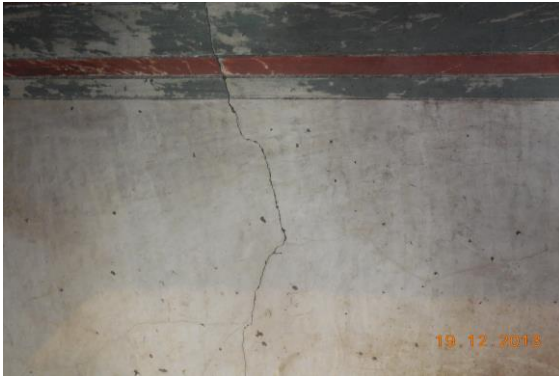
Photo 60
Peeling of Plaster on Floor of Room No. 5 of Ground Floor

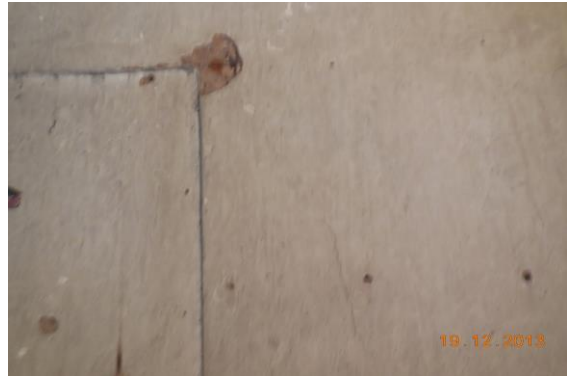
Photo 61

Plaster Crack on Wall No. 5 of Room No. 5 of Ground Floor

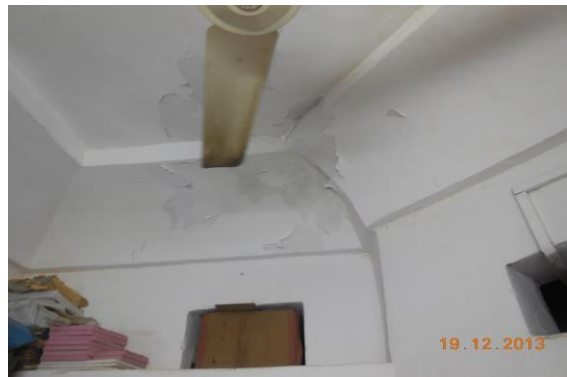
Photo 63

Plaster Crack on Wall No. 1 of Room No. 6 of Ground Floor

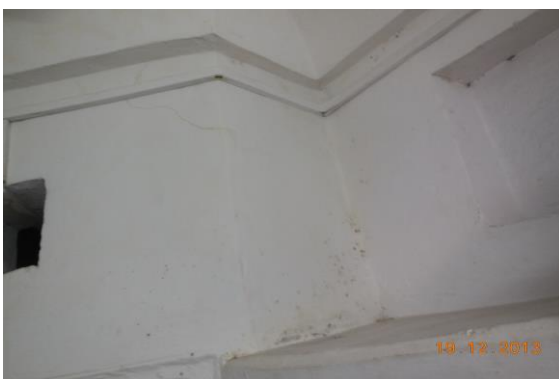
Photo 64

Peeling of Plaster on Roof of Room No. 10 of Ground Floor

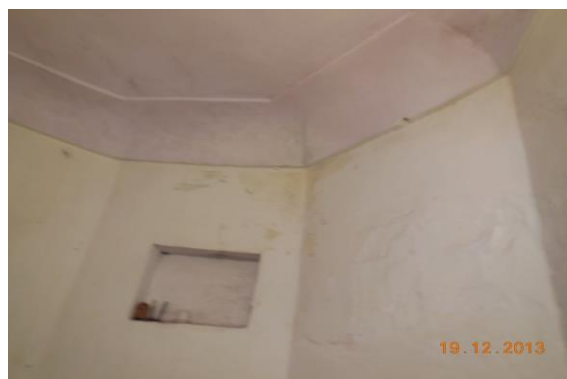
Photo 65

Dampness/Seepage on Wall No. 2 of Room No. 10 of Ground Floor

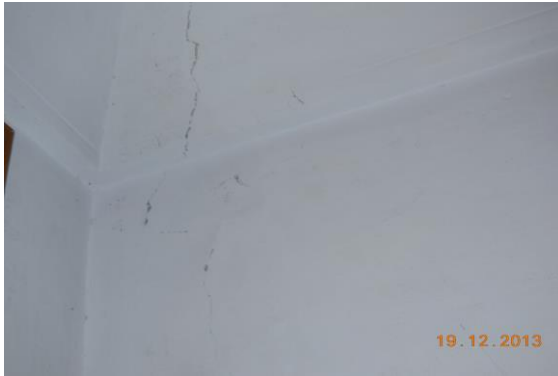
Photo 66

Dampness/Seepage on Wall No. 2, 4 & Roof of Tomb area No.2 of Ground Floor

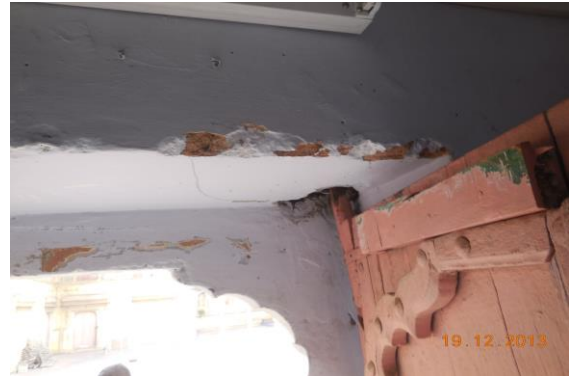
Photo 67

Plaster Crack on Wall No. 4 & Roof of Room No. 12 of Ground Floor

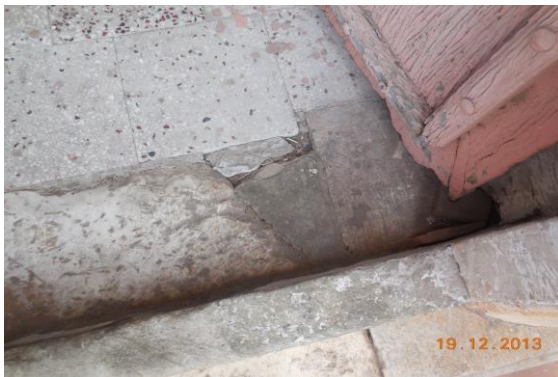
Photo 68

Peeling of Plaster on Wall No. 3 of Room No. 12 of Ground Floor

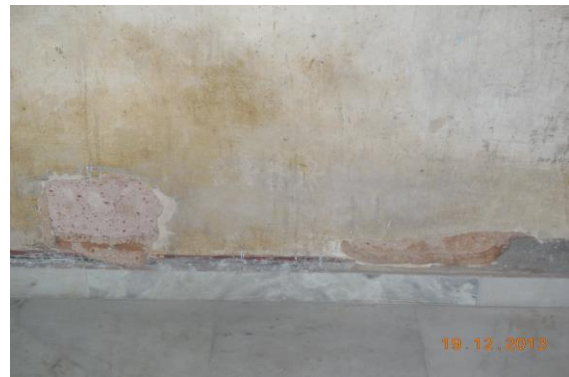
Photo 69

Peeling of Plaster on Floor of Room No. 12 of Ground Floor

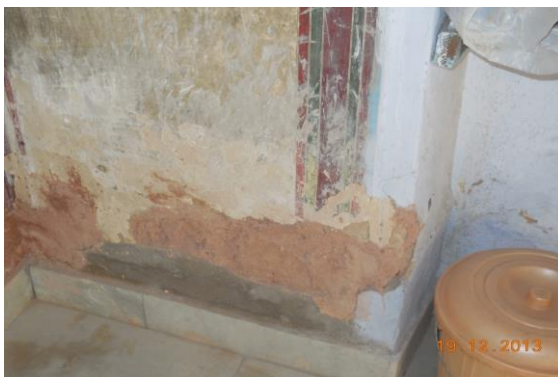
Photo 70

Peeling of Plaster on Wall No. 4 of Room No. 14 of Ground Floor

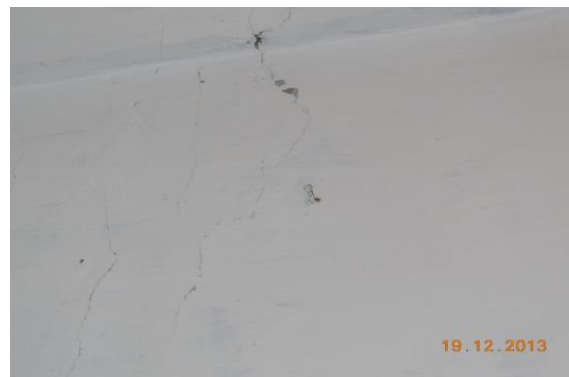
Photo 71

Peeling of Plaster on Wall No. 2 of Room No. 14 of Ground Floor

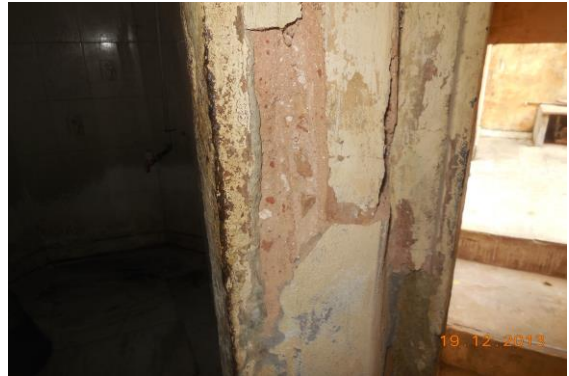
Photo 73

Peeling of Plaster on Wall No. 4 of Room No. 16 of Ground Floor

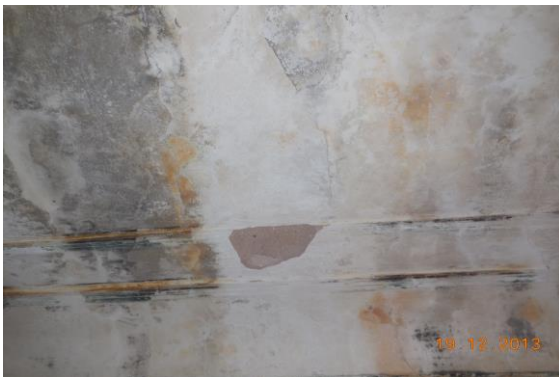
Photo 74

Peeling of Plaster on Wall No. 1 of Tomb + Bathroom of Ground Floor

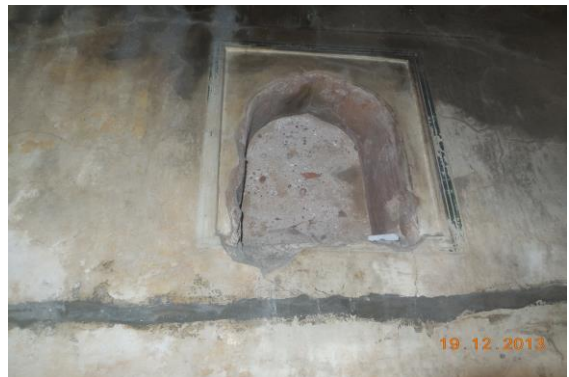
Photo 75

Peeling of Plaster on Roof of Varanda No.3 of Ground Floor

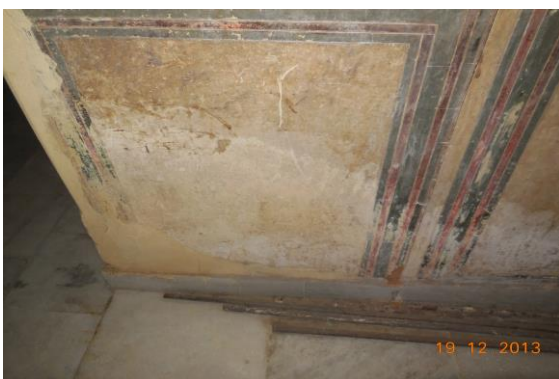
Photo 76

Peeling of Plaster on Wall No. 3 of Varanda No.3 of Ground Floor

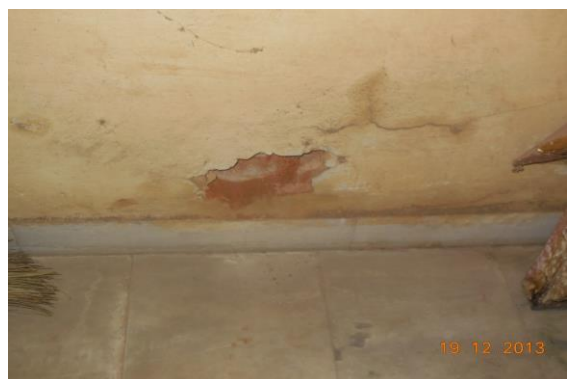
Photo 77

Peeling of Plaster on Wall No. 6 of Varanda No.3 of Ground Floor

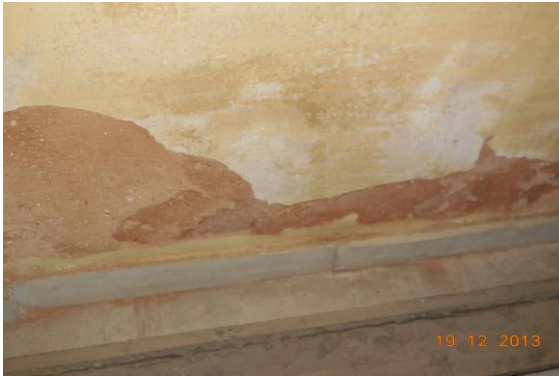
Photo 78

Damaged Portion on Wall No. 4 of Varanda No.3 of Ground Floor

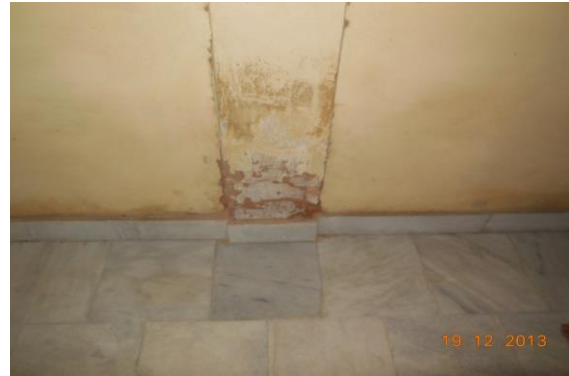
Photo 79

Peeling of Plaster on Wall No. 4 of Varanda No.3 of Ground Floor

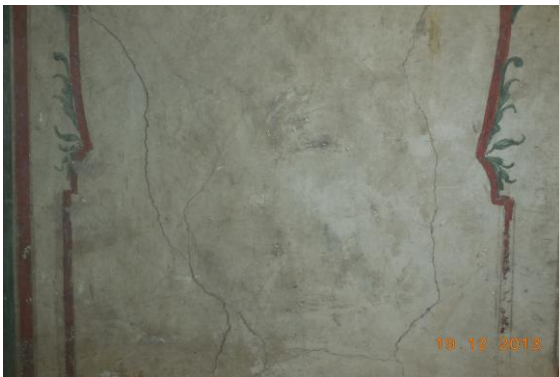
Photo 80

Peeling of Plaster on Wall No. 7 of Varanda No.3 of Ground Floor

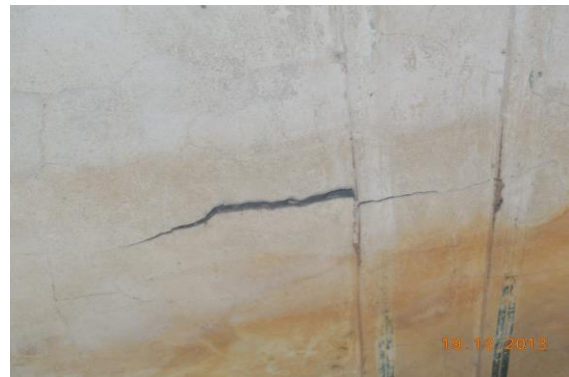
Photo 81

Peeling of Plaster on Wall No. 2 of Varanda No.3 of Ground Floor

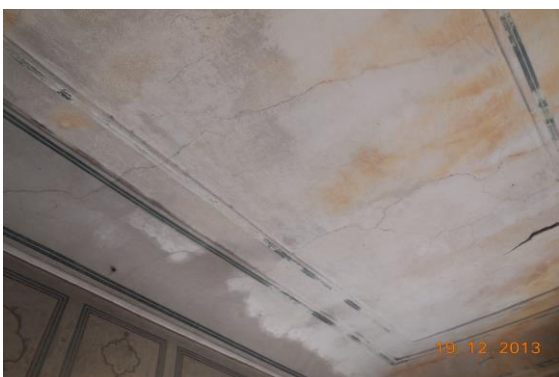
Photo 82

Peeling of Plaster on Roof of Varanda No.3 of Ground Floor

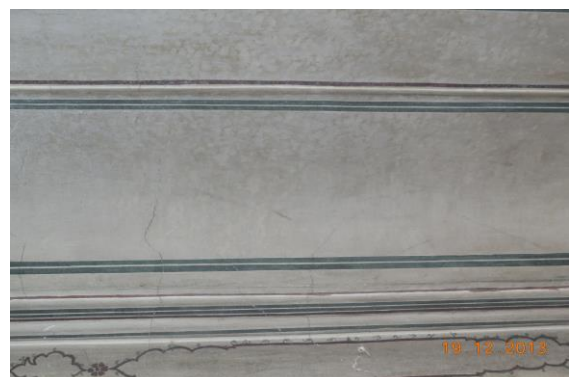
Photo 83

Plaster Crack on Roof of Varanda No.3 of Ground Floor

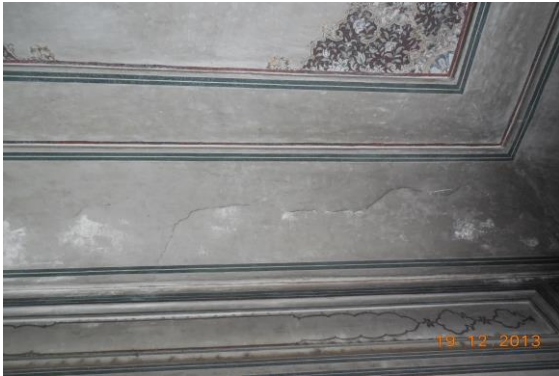
Photo 84

Plaster Crack on Roof of Varanda No.3 of Ground Floor

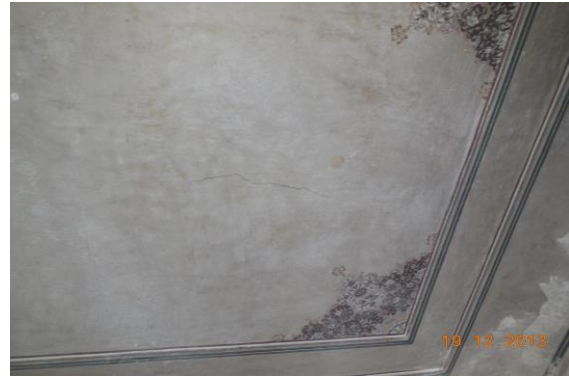
Photo 85
Plaster Crack on Roof of Varanda No.3 of Ground Floor

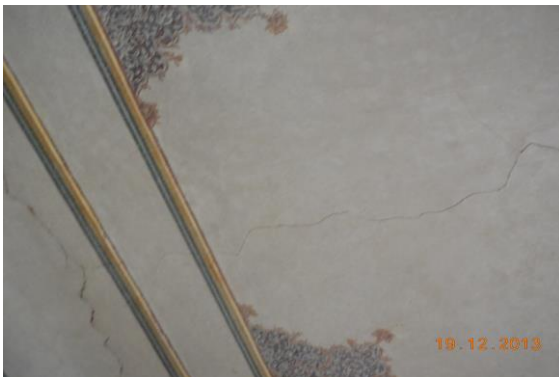
Photo 86
Plaster Crack on Roof of Varanda No.3 of Ground Floor

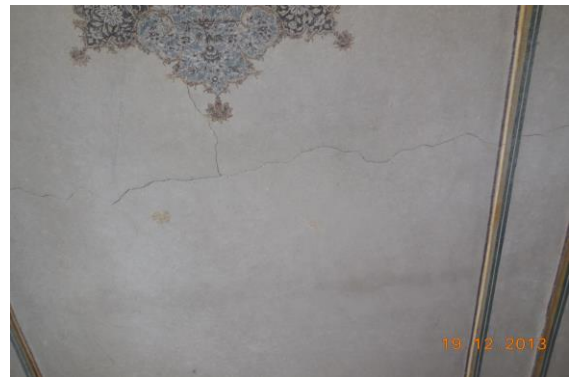
Photo 87
Plaster Crack on Roof of Varanda No.3 of Ground Floor

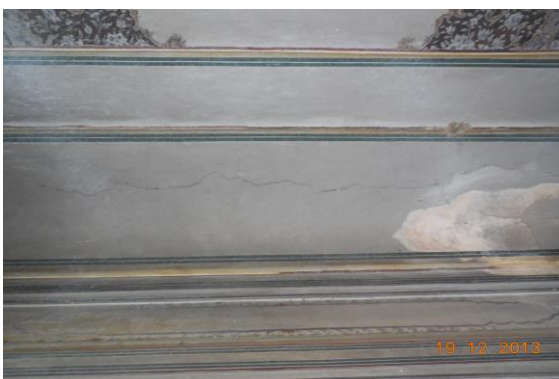
Photo 88
Plaster Crack on Roof of Varanda No.3 of Ground Floor

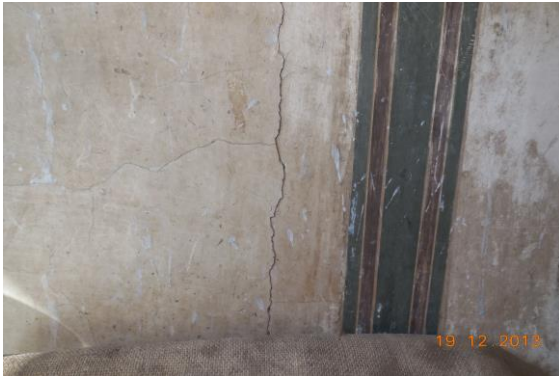
Photo 91

Plaster Crack on Wall No. 1 of Varanda No.4 of Ground Floor

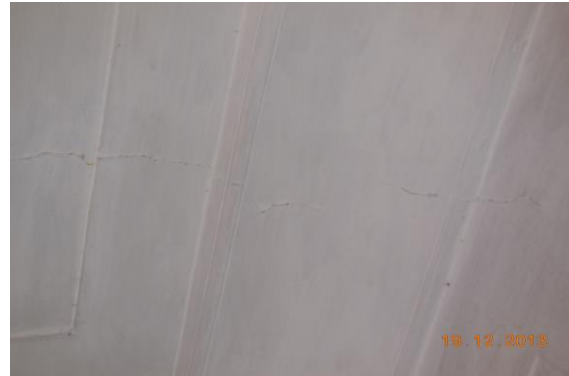
Photo 92

Plaster Crack on Roof of Varanda No.4 of Ground Floor

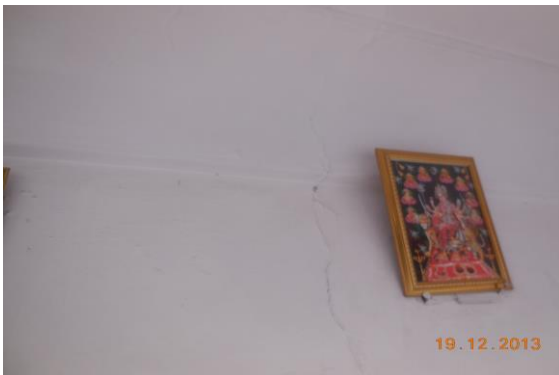
Photo 93

Plaster Crack on Wall No. 4 & Roof of Varanda No.2 of Ground Floor

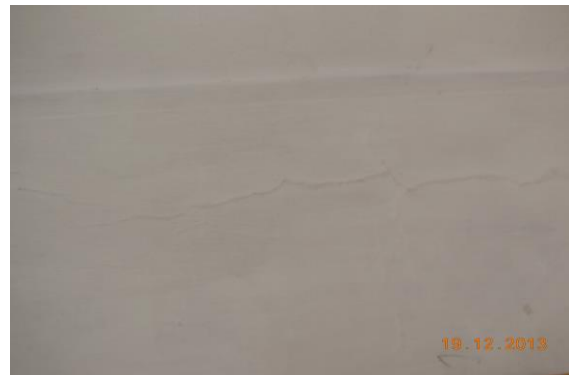
Photo 94

Plaster Crack on Roof of Varanda No.2 of Ground Floor

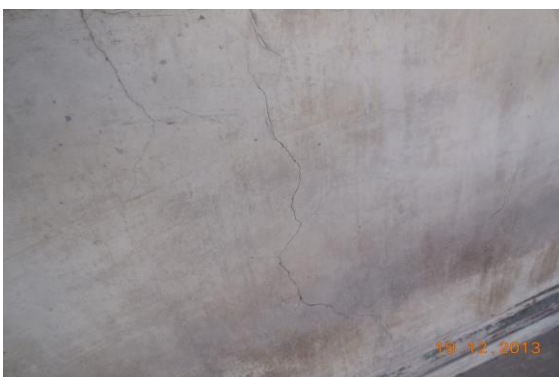
Photo 95

Plaster Crack on Wall No. 4 of Varanda No.2 of Ground Floor

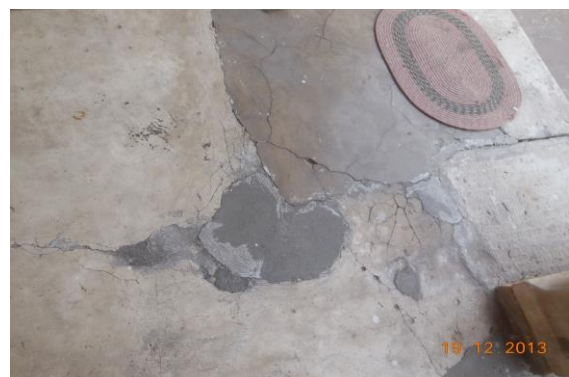
Photo 96

Plaster Crack on Floor of Varanda No.2 of Ground Floor

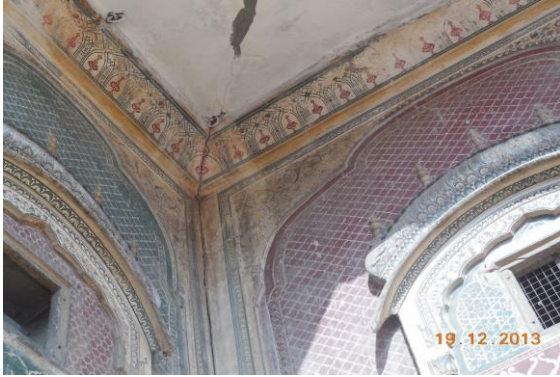
Photo 97

Peeling of Plaster on Wall No. 2 & 4 of Open Sky of Ground Floor

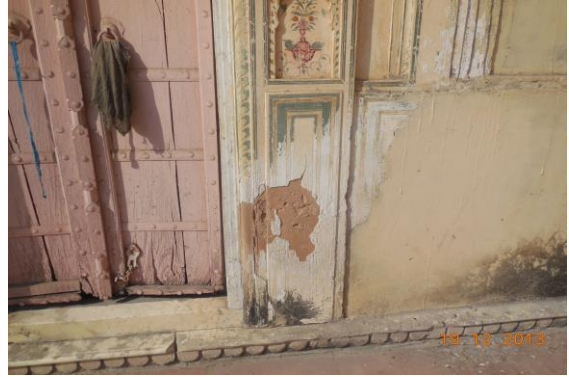
Photo 98

Peeling of Plaster on Wall No. 4 of Open Sky of Ground Floor

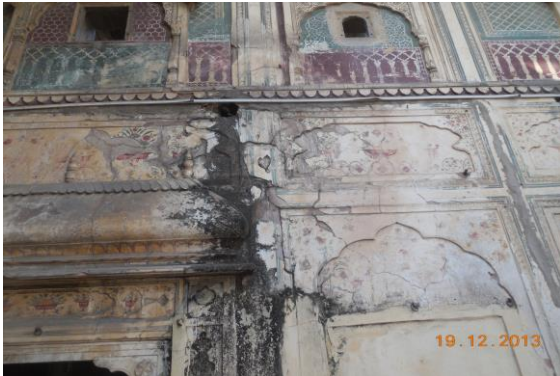
Photo 99

Damaged Portion on Wall No. 4 of Open Sky of Ground Floor

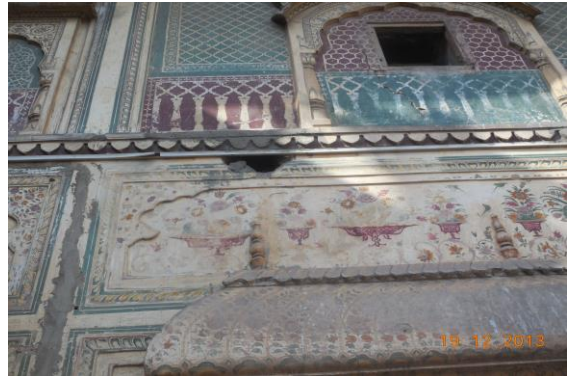
Photo 100

Damaged Portion on Wall No. 4 of Open Sky of Ground Floor

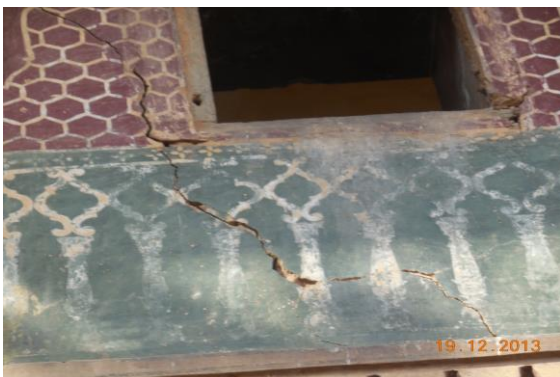
Photo 101

Damaged Portion on Wall No. 4 of Open Sky of Ground Floor

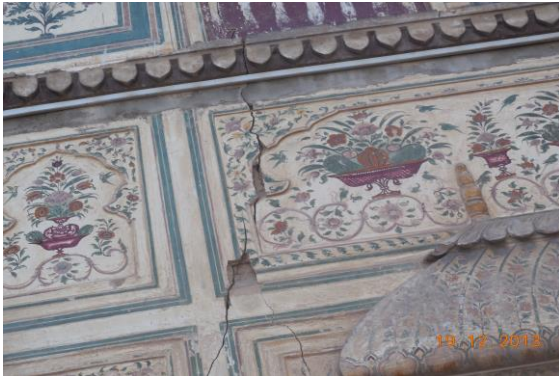
Photo 103
Damaged Portion on Wall No. 1 of Open Sky of Ground Floor

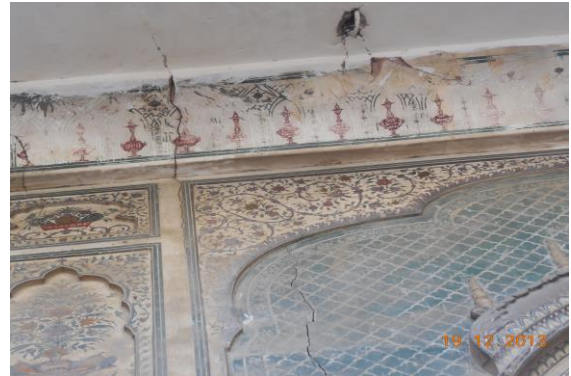
Photo 104
Damaged Portion on Wall No. 1 of Open Sky of Ground Floor

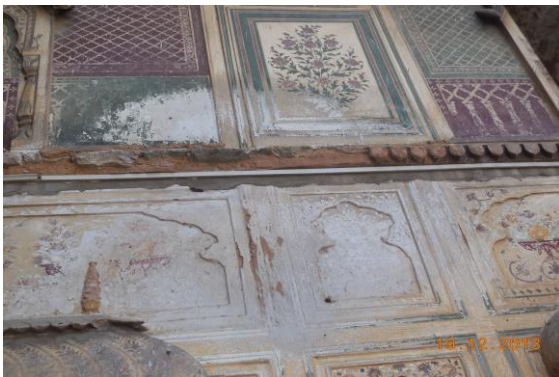
Photo 105
Peeling of Plaster on Wall No. 1 of Open Sky of Ground Floor

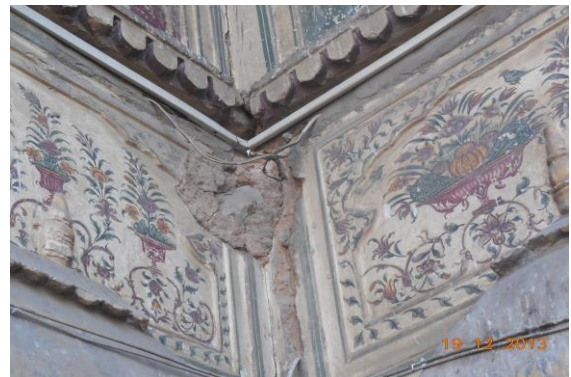
Photo 106
Peeling of Plaster on Wall No. 3 of Open Sky of Ground Floor

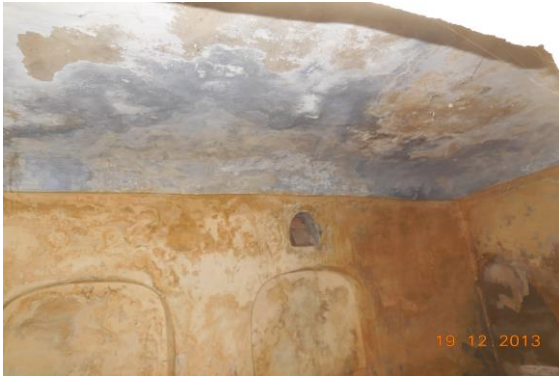
Photo 109

Dampness/Seepage on Wall No. 2, 4 & Roof of Room No. 1 of Lower Ground Floor

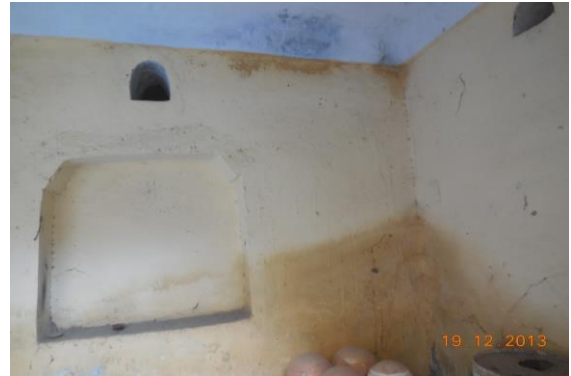
Photo 110

Dampness/Seepage on Wall No. 2 & 4 of Varanda of Lower Ground Floor

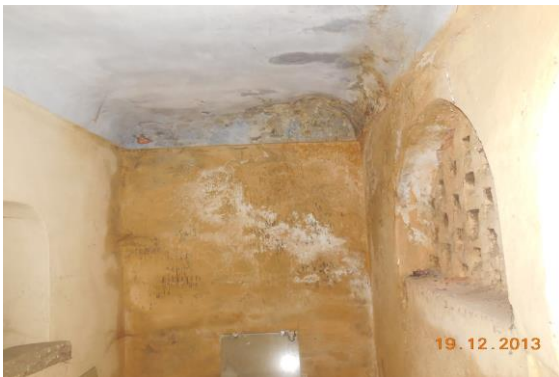
Photo 111

Dampness/Seepage on Wall No. 2, 3 & Roof of Room No. 2 of Lower Ground Floor

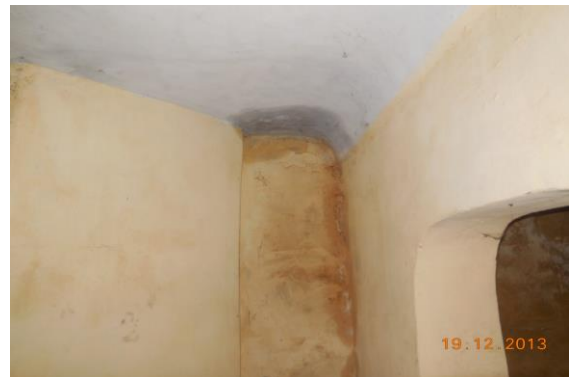
Photo 112

Dampness/Seepage on Wall No. 2 of Room No. 3 of Lower Ground Floor

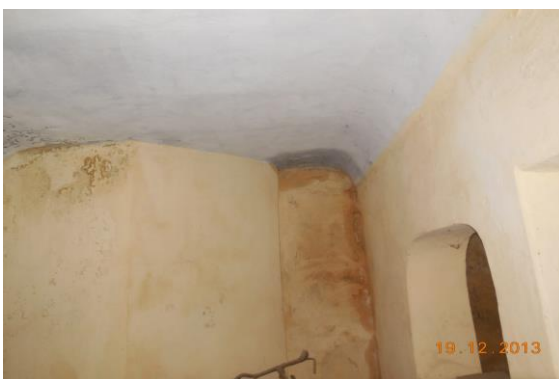
Photo 113

Dampness/Seepage on Wall No. 2 of Room No. 3 of Lower Ground Floor

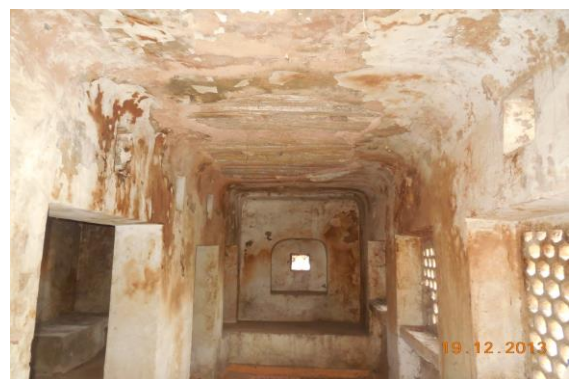
Photo 114

Dampness/Seepage on All walls & Roof of Varanda No.1 of Lower First Floor

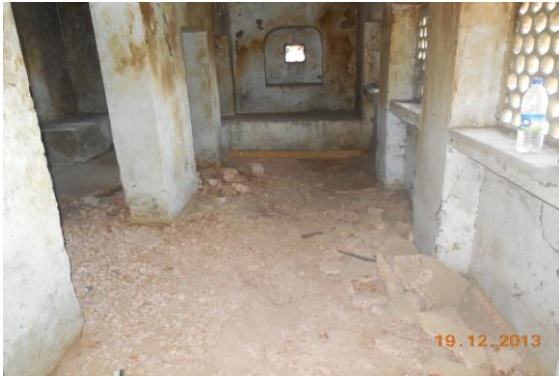
Photo 115
Peeling of Plaster on of Varanda No.1 of Lower First Floor

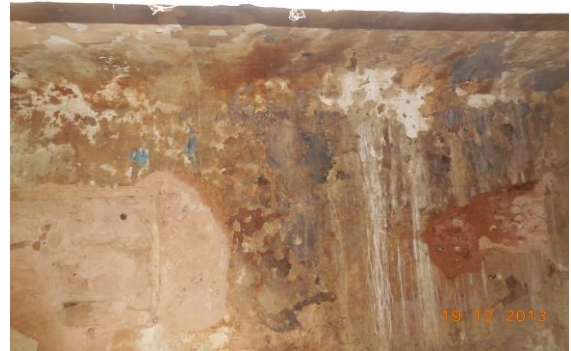
Photo 116
Damaged Portion on Wall No. 4 & Roof of Varanda No.2 of Lower First Floor

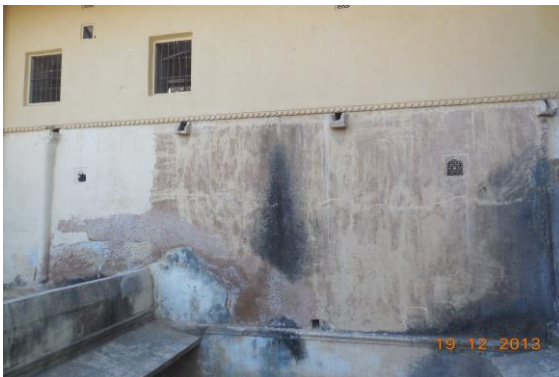
Photo 117
Damaged Portion on Backside view of of Lower First Floor

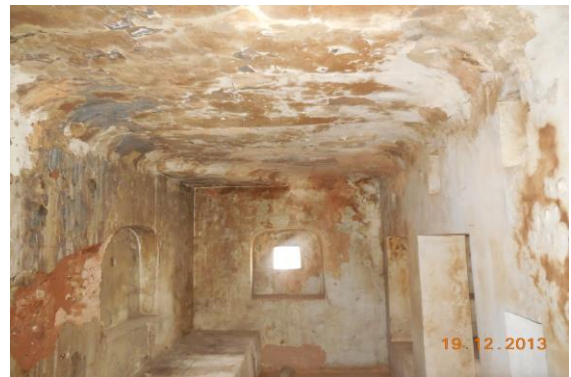
Photo 118
Damaged Portion on Roof of Varanda No.2 of Lower First Floor

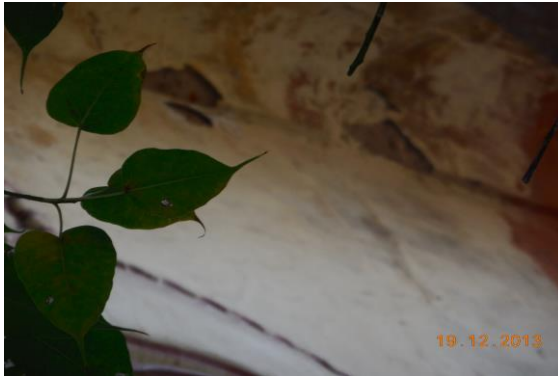
Photo 121

Peeling of Plaster on Right Handside Sun Shade of Lower First Floor
