Pre Building Condition Survey Report

Name and Address of Structure :	Choti Chopar to Badi Chopar (UP Line)
---------------------------------	---------------------------------------

Name of the Project	Contract JMRC-UG1B “Design and Construction of Tunnel between Chandpole and Badi Chouper and reverse line by Shield TBM, Underground Metro Stations at Choti Chouper and Badi Chouper by Cut and Cover Methods on East West Corridor of Jaipur Metro Rail Corporation Limited .”	
Owner :

Shoping Complex - Shop No. 169-188
Tripolia Bazar
Jaipur
Unique ID: CC BC UP 0001

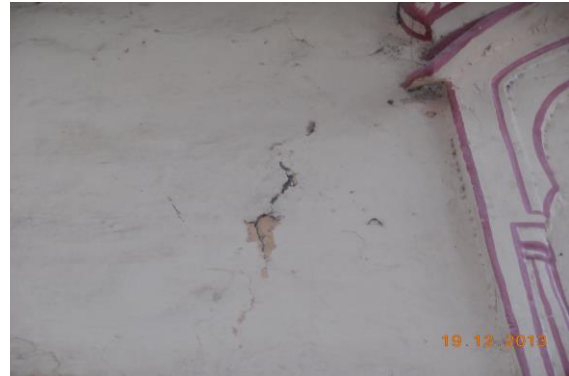
Photo 122

Peeling of Plaster on Right Handside Sun Shade of Lower First Floor

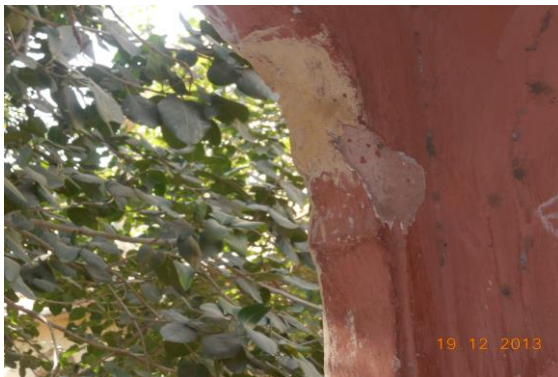
Photo 123

Peeling of Plaster on Wall No. 4 of Minarates No.1 of First Floor

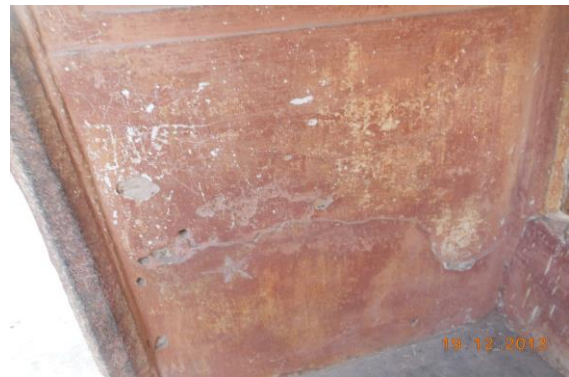
Photo 124

Peeling of Plaster on Wall No. 1 of Minarates No.1 of First Floor

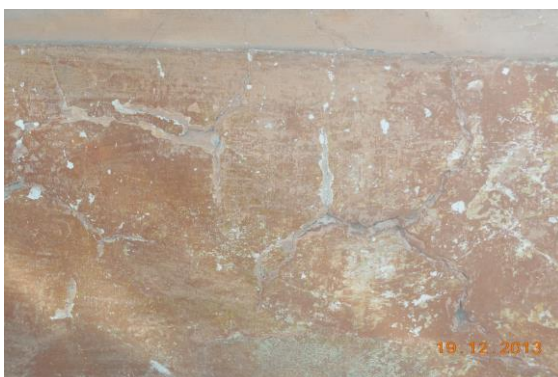
Photo 125

Peeling of Plaster on Wall No. 2 of Minarates No.1 of First Floor

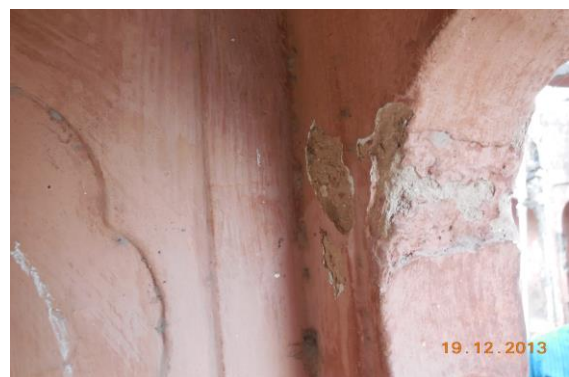
Photo 126

Peeling of Plaster on Wall No. 3 of Minarates No.1 of First Floor

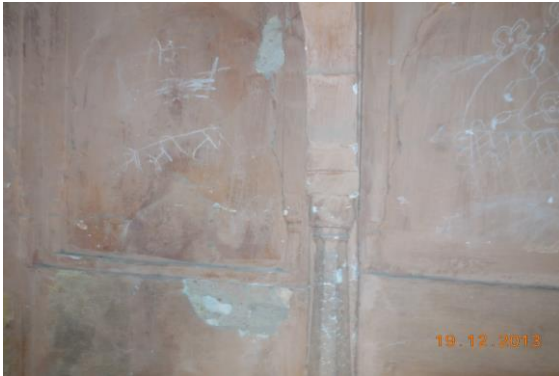
Photo 127

Peeling of Plaster on Wall No. 4 of Minarates No.2 of First Floor

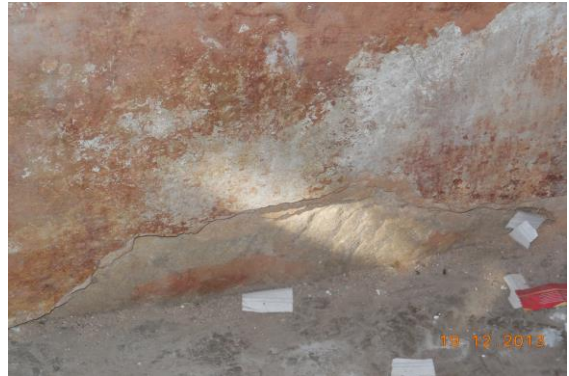
Photo 128

Peeling of Plaster on Wall No. 1 of Minarates No.2 of First Floor

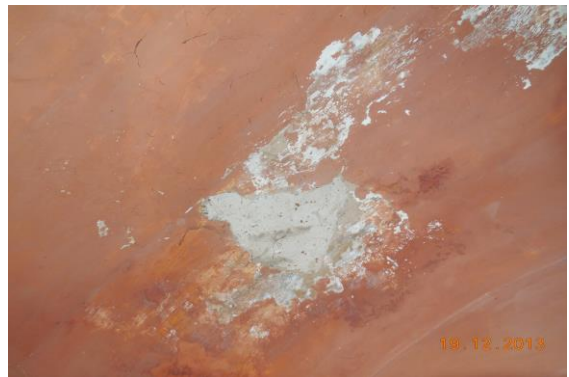
Photo 130

Peeling of Plaster on Roof of Minarates No.2 of First Floor

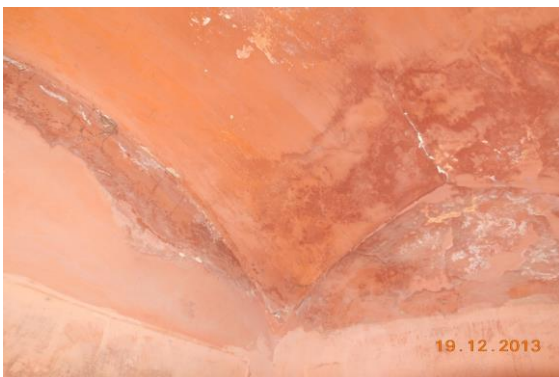
Photo 131

Dampness/Seepage on Roof, 1 & 4 of Minarates No.2 of First Floor

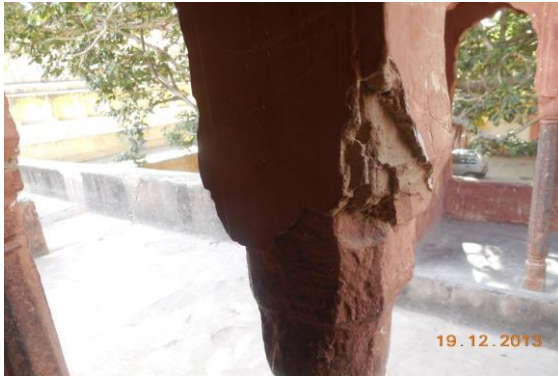
Photo 133
Dampness/Seepage on Wall No. 3 of Minarates No.2 of First Floor

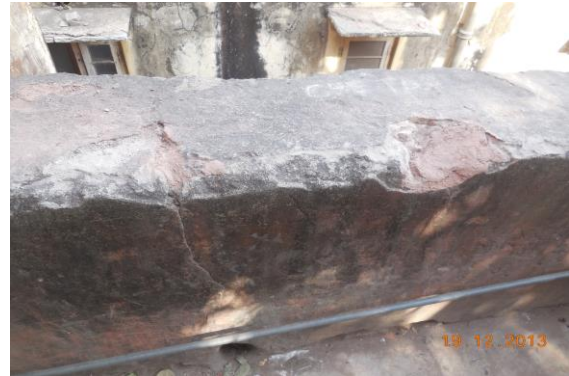
Photo 134
Peeling of Plaster on Wall No. 1 of Open Sky Area No.1 of First Floor

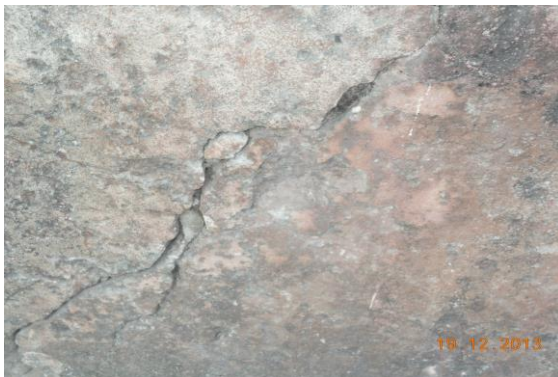
Photo 135
Damaged Portion on Wall No. 1 of Open Sky Area No.1 of First Floor

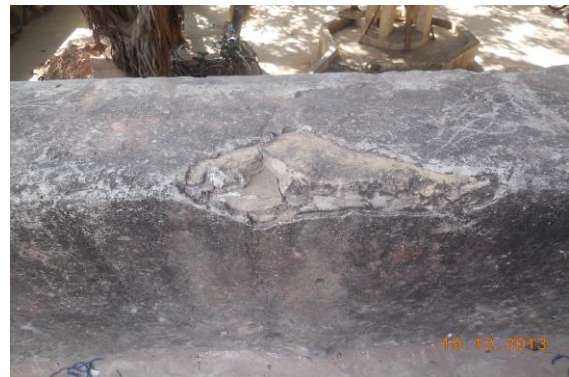
Photo 136
Peeling of Plaster on Wall No. 1 of Open Sky Area No.1 of First Floor

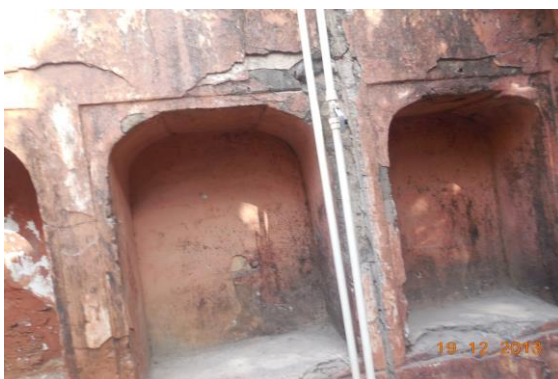
Photo 137
Damaged Portion on Wall No. 2 of Open Sky Area No.1 of First Floor

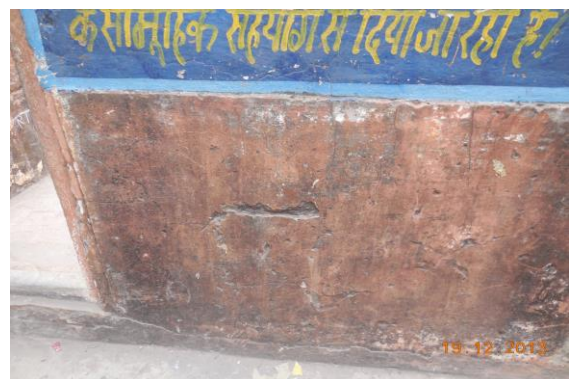
Photo 138
Peeling of Plaster on Wall No. 4 of Open Sky Area No.1 of First Floor

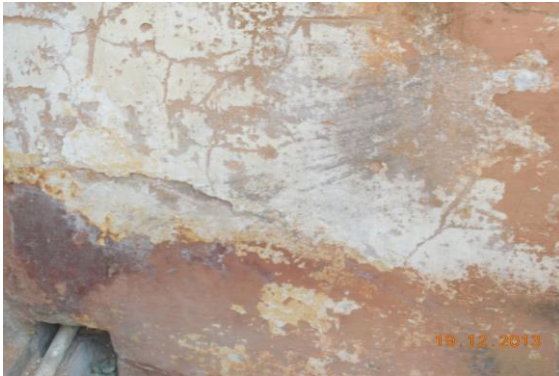
Photo 139

Peeling of Plaster on Wall No. 3 of Open Sky Area No.2 of First Floor

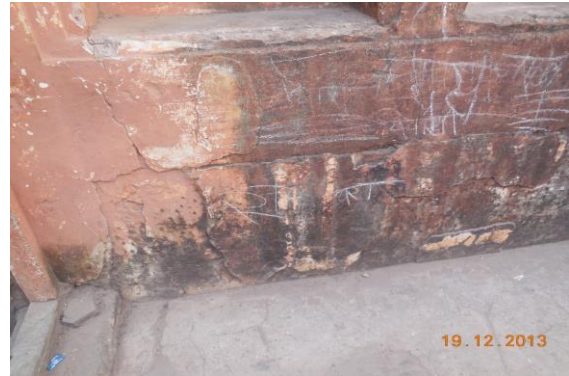
Photo 140

Peeling of Plaster on Wall No. 1 of Open Sky Area No.2 of First Floor

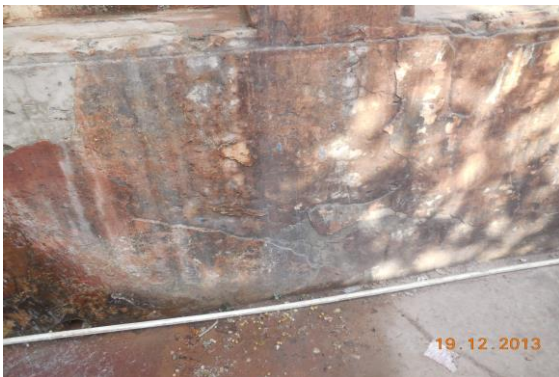
Photo 141

Peeling of Plaster on Wall No. 2 of Open Sky Area No.2 of First Floor

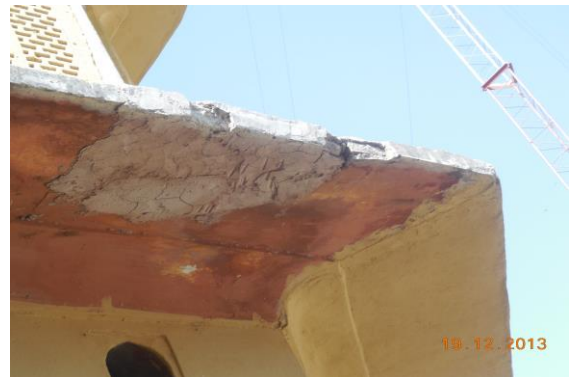
Photo 142

Damaged Portion on Sun Shade of Open Sky Area No.2 of First Floor

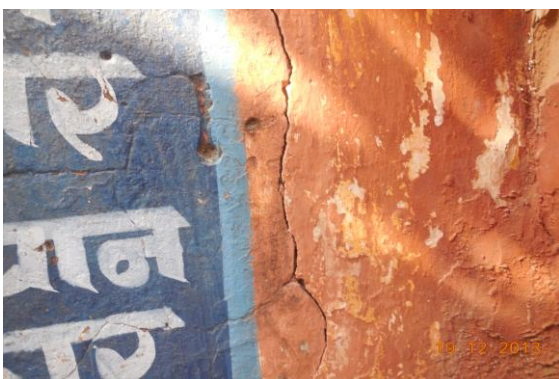
Photo 143

Damaged Portion on Wall No. 4 of Open Sky Area No.1 of First Floor

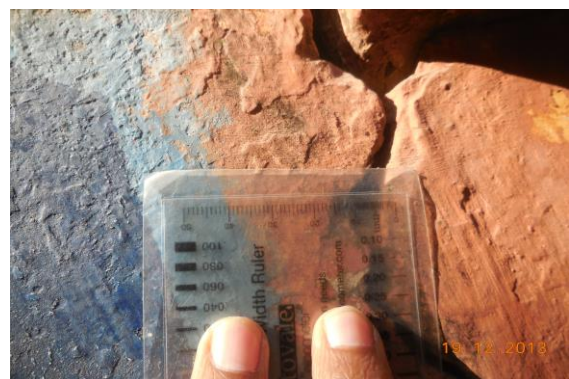
Photo 144

Damaged Portion on Wall No. 4 of Open Sky Area No.1 of First Floor

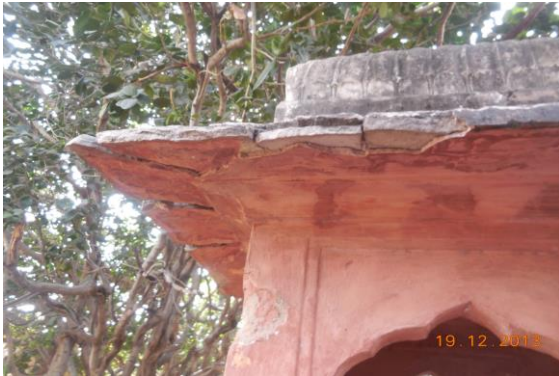
Photo 145
Damaged Portion on Sun Shade of Minarates No.1 of First Floor

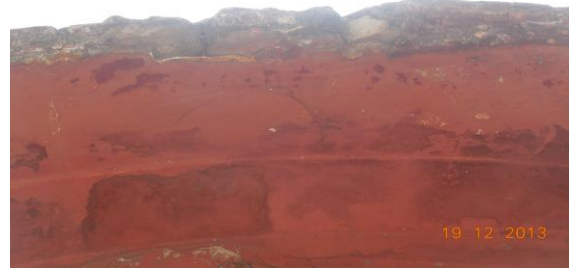
Photo 146
Damaged Portion on Sun Shade of Minarates No.2 of First Floor

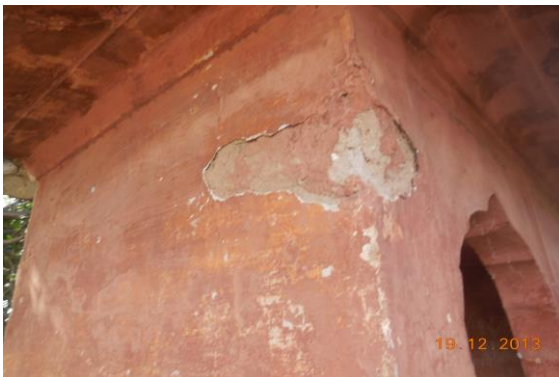
Photo 147
Peeling of Plaster on Outer Wall of Minarates No.1 of First Floor

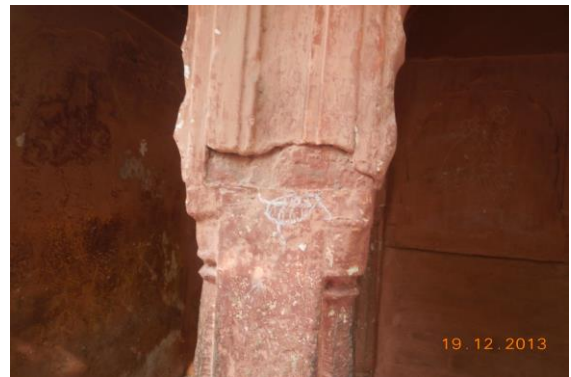
Photo 148
Peeling of Plaster on Outer Wall of Minarates No.2 of First Floor

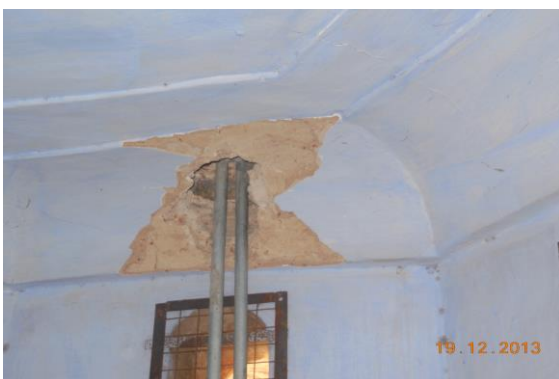
Photo 149
Exposed Reinforcement on Roof & 2 of Tomb No.2 of First Floor

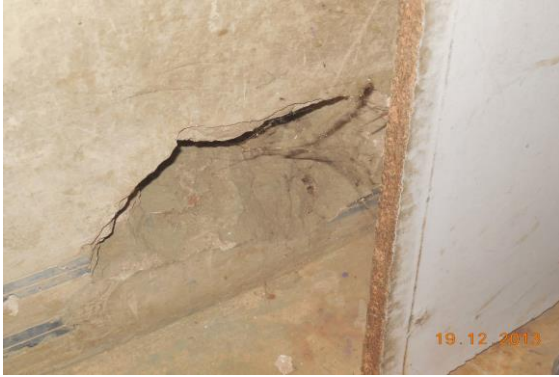
Photo 151
Damaged Portion on Wall No. 1 of Tomb No.2 of First Floor

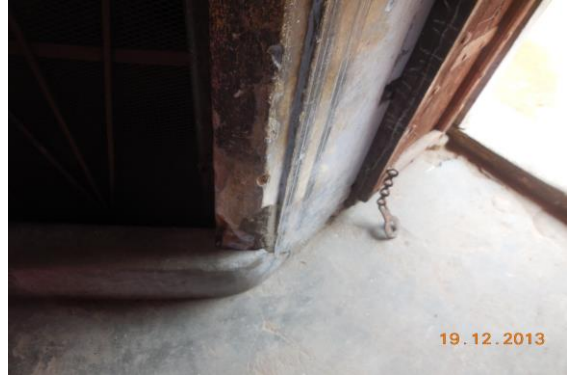
Photo 152
Peeling of Plaster on Outer Wall of Tomb No.2 of First Floor

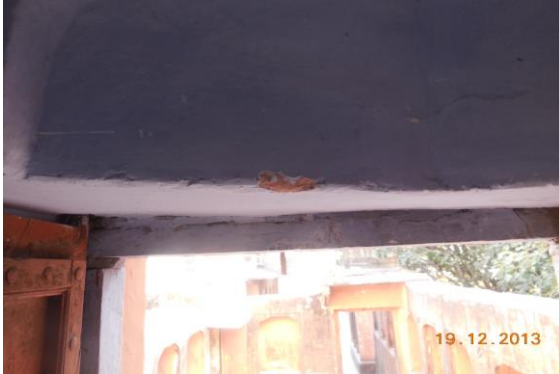
Photo 153
Peeling of Plaster on Wall No. 3 of Room No. 1 of School, First Floor

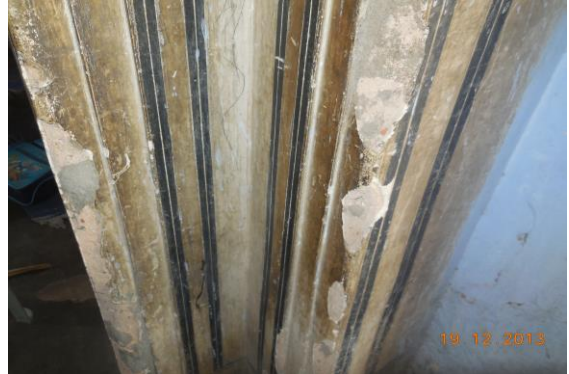
Photo 154
Peeling of Plaster on Wall No. 2 of Room No. 1 of School, First Floor

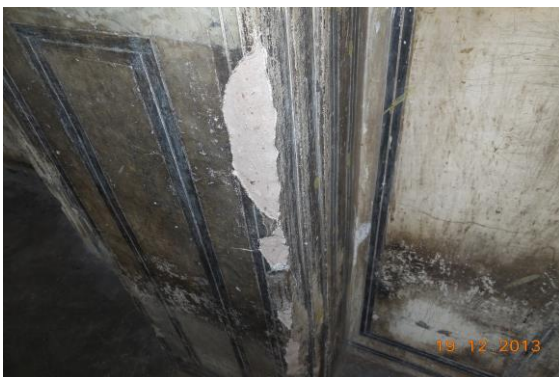
Photo 155
Peeling of Plaster on Wall No. 1 of Room No. 1 of School, First Floor

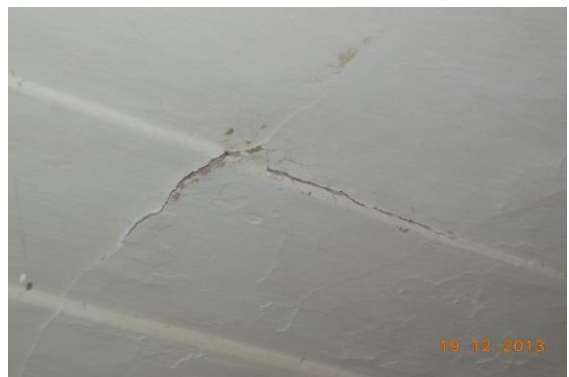
Photo 156
Peeling of Plaster on Roof of Room No. 1 of School, First Floor

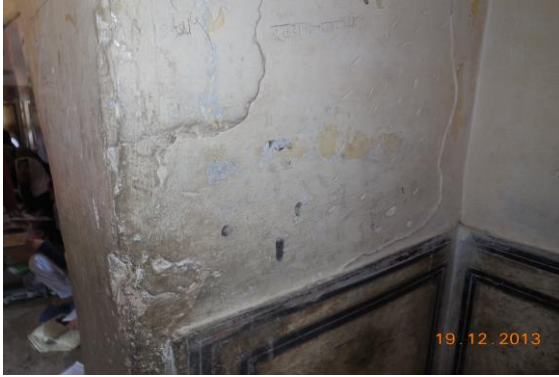
Photo 157

Peeling of Plaster on Wall No. 4 of Room No. 1 of School, First Floor

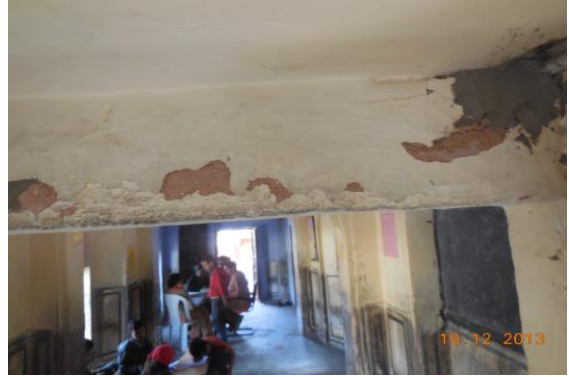
Photo 158

Peeling of Plaster on Wall No. 3 of Room No. 2 of School, First Floor

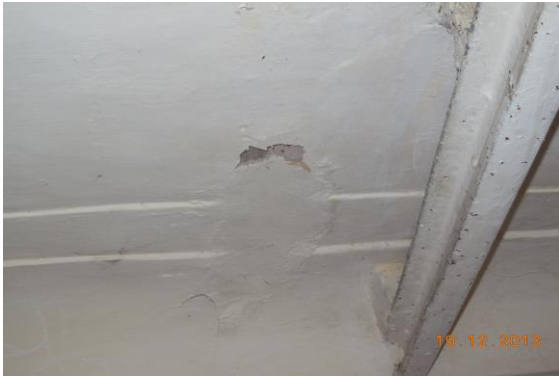
Photo 159

Damaged Portion on Roof of Room No. 2 of School, First Floor

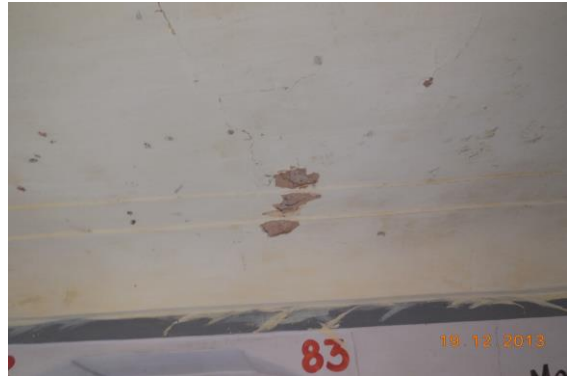
Photo 160

Damaged Portion on Roof of Room No. 2 of School, First Floor

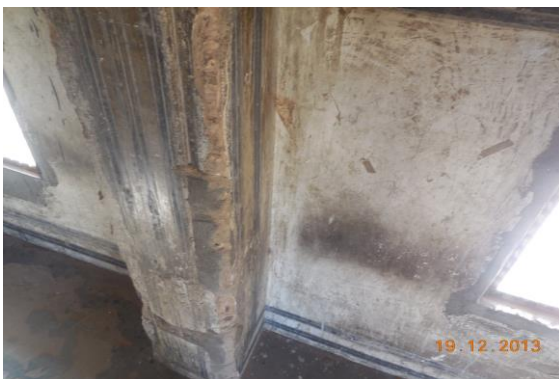
Photo 161

Peeling of Plaster on Wall No. 2 of Room No. 2 of School, First Floor

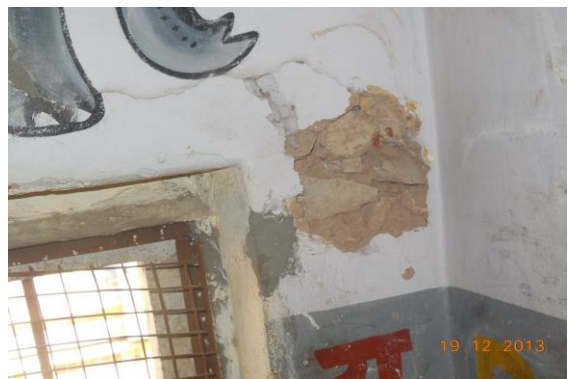
Photo 162

Peeling of Plaster on Wall No. 1 of Room No. 2 of School, First Floor

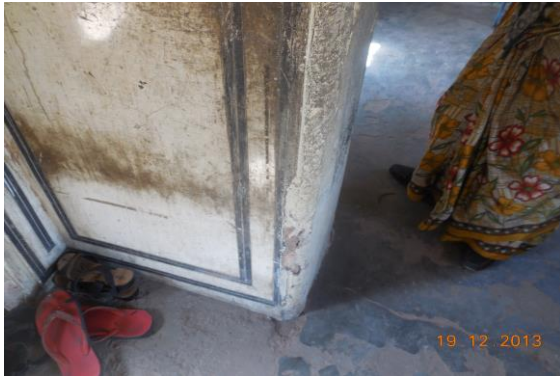
Photo 163

Peeling of Plaster on Wall No. 4 of Room No. 2 of School, First Floor

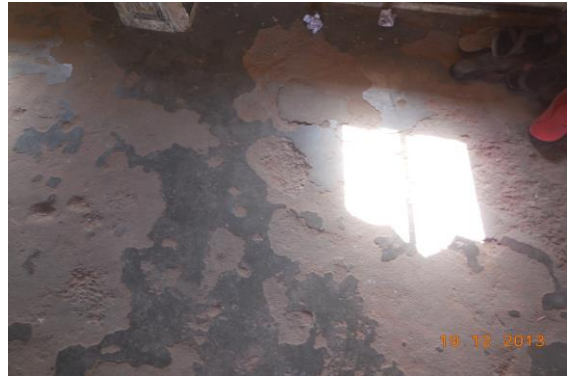
Photo 164

Peeling of Plaster on Floor of Room No. 2 of School, First Floor

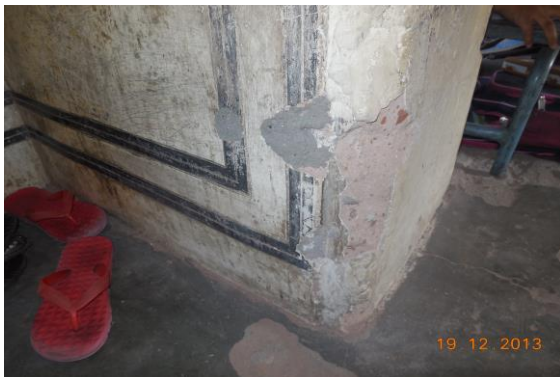
Photo 165

Peeling of Plaster on Wall No. 3 of Room No. 3 of School, First Floor

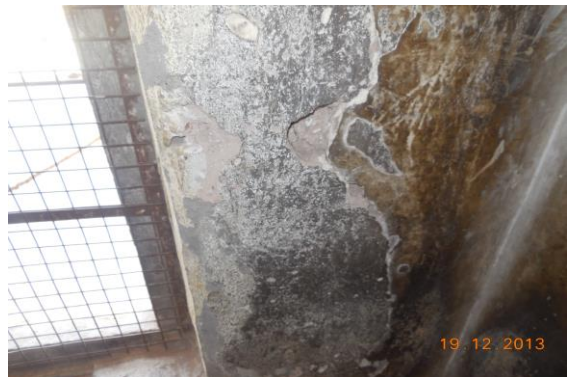
Photo 166

Damaged Portion on Wall No. 2 of Room No. 3 of School, First Floor

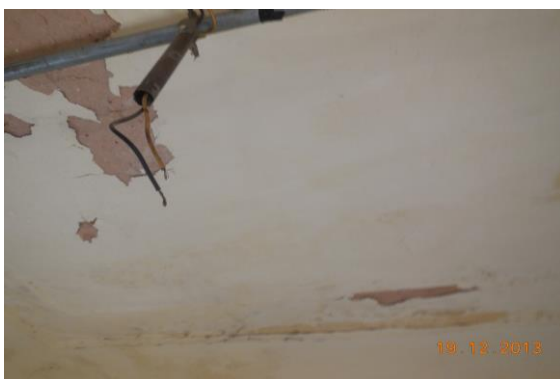
Photo 167

Peeling of Plaster on Roof of Room No. 4 of School, First Floor

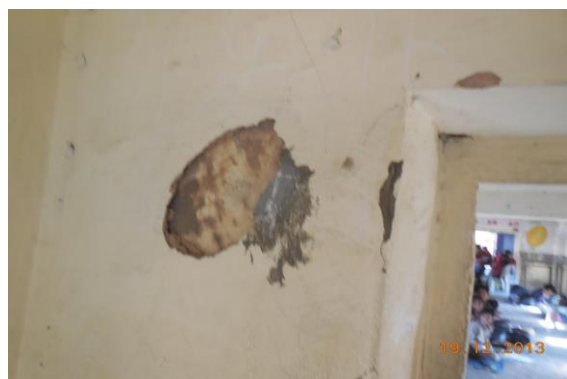
Photo 168

Peeling of Plaster on Wall No. 3 of Room No. 4 of School, First Floor

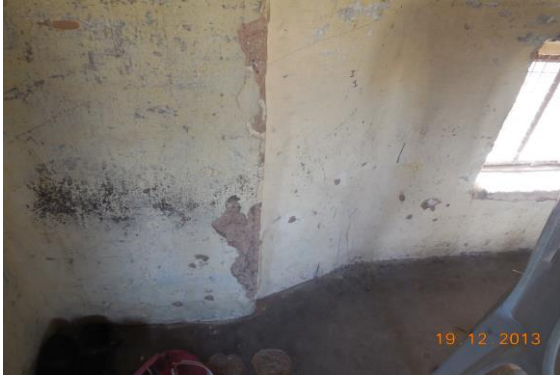
Photo 169

Peeling of Plaster on Wall No. 1 of Room No. 4 of School, First Floor

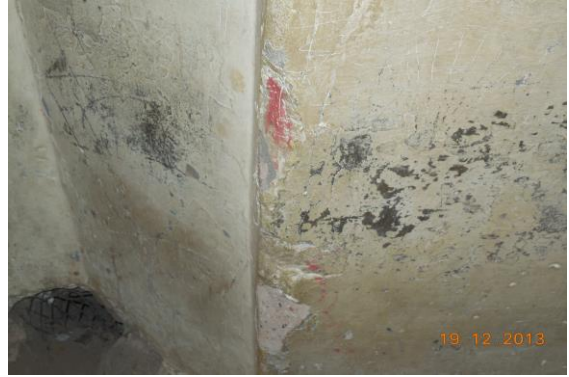
Photo 170

Peeling of Plaster on Wall No. 2 of Room No. 4 of School, First Floor

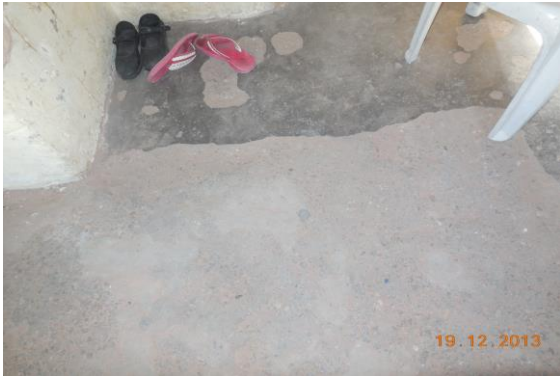
Photo 171

Peeling of Plaster on Floor of Room No. 4 of School, First Floor

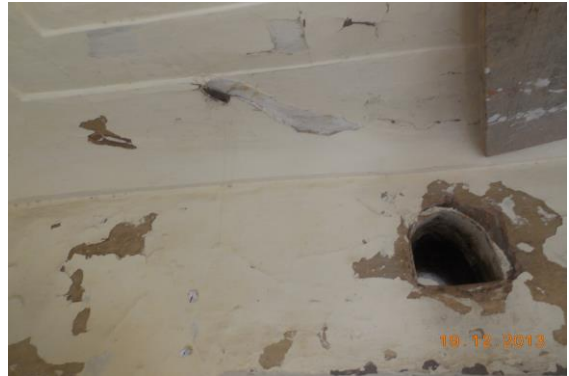
Photo 172

Peeling of Plaster on Roof & 3 of Room No. 5 of School, First Floor

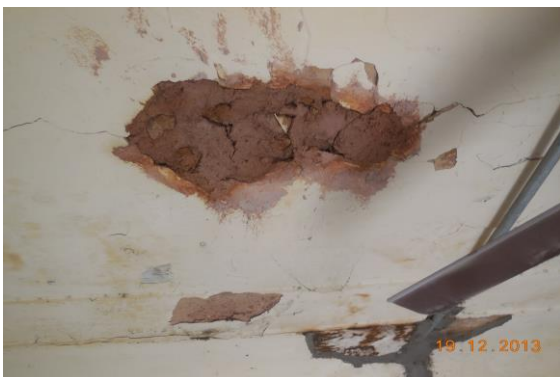
Photo 173

Damaged Portion on Roof of Room No. 5 of School, First Floor

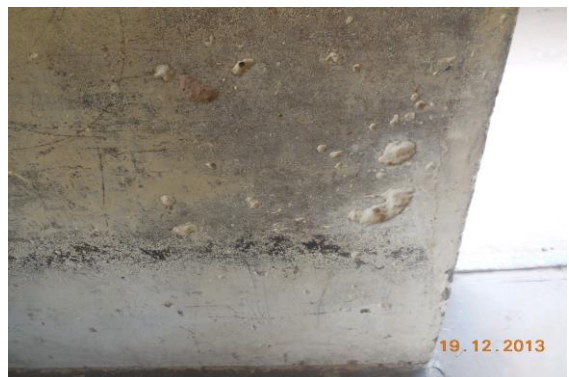
Photo 174

Peeling of Plaster on Wall No. 1 of Room No. 5 of School, First Floor

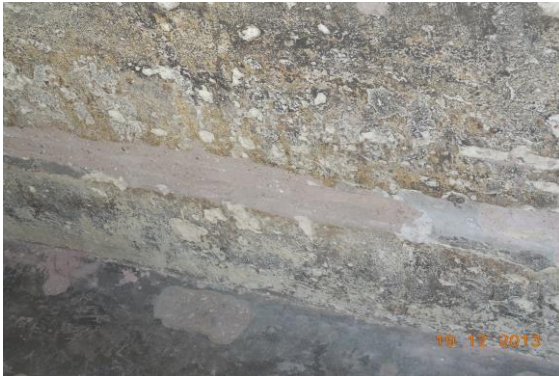
Photo 175

Peeling of Plaster on Wall No. 2 of Room No. 5 of School, First Floor

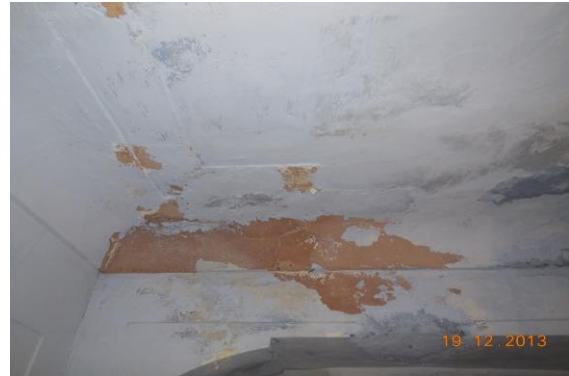
Photo 176

Peeling of Plaster on Roof & 1 of Room No. 7 of School, First Floor

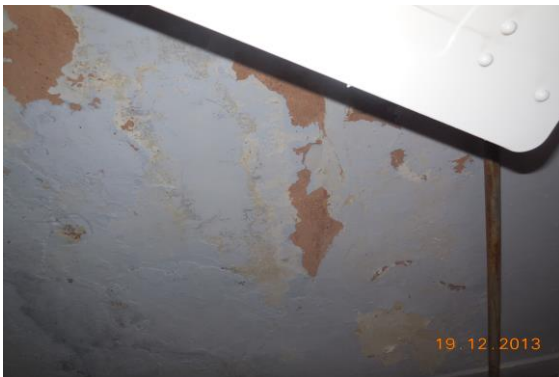
Photo 177

Dampness/Seepage on Roof of Room No. 7 of School, First Floor

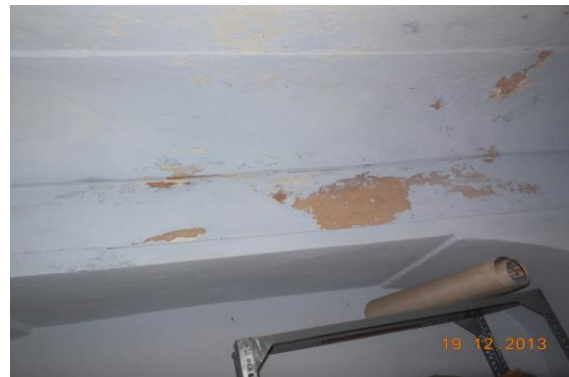
Photo 178

Dampness/Seepage on Wall No. 2 of Room No. 7 of School, First Floor

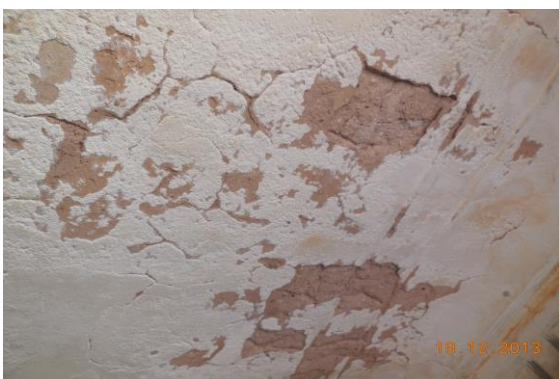
Photo 179

Damaged Portion on Roof of School, First Floor

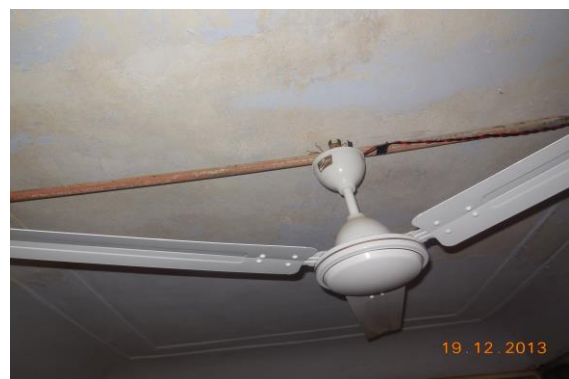
Photo 180

Peeling of Plaster on Roof of Room No. 6 of School, First Floor

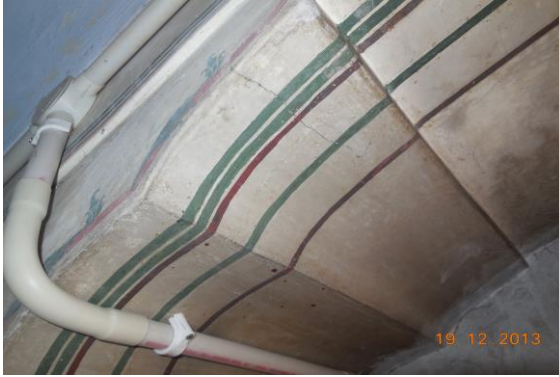
Photo 181

Plaster Crack on Wall No. 3 of Room No. 6 of School, First Floor

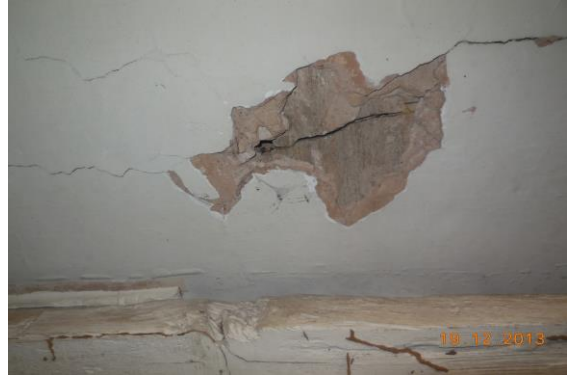
Photo 182

Damaged Portion on Roof of Room No. 10 of School, First Floor

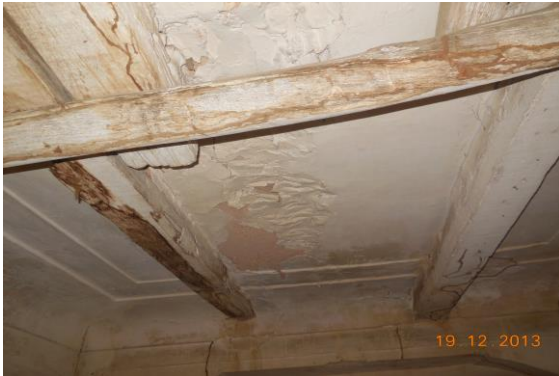
Photo 183

Damaged Portion on Roof of Room No. 10 of School, First Floor

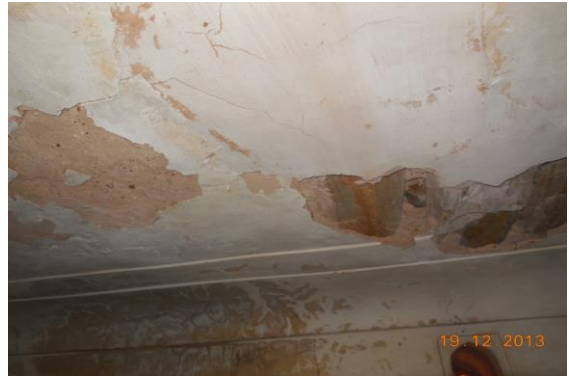
Photo 184

Damaged Portion on Roof of Room No. 11 of School, First Floor

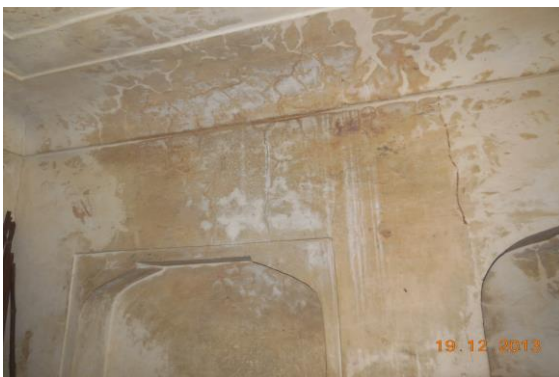
Photo 185

Dampness/Seepage on Wall No. 4 of Room No. 11 of School, First Floor

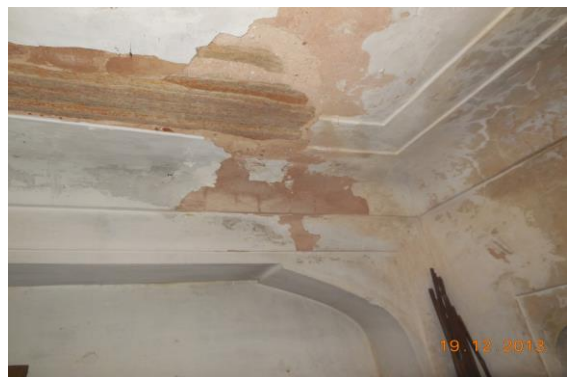
Photo 186

Peeling of Plaster on Wall No. 1 of Room No. 11 of School, First Floor

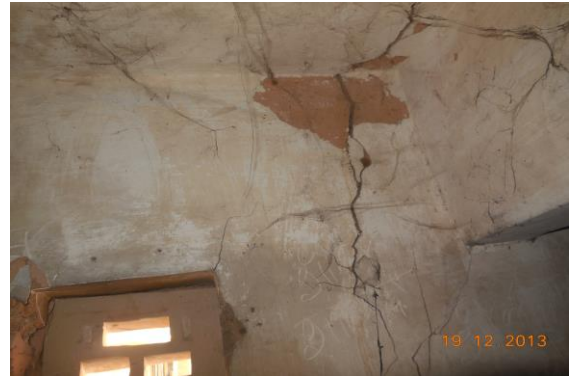
Photo 188
Damaged Portion on Wall No. 1 of Staircase of First Floor

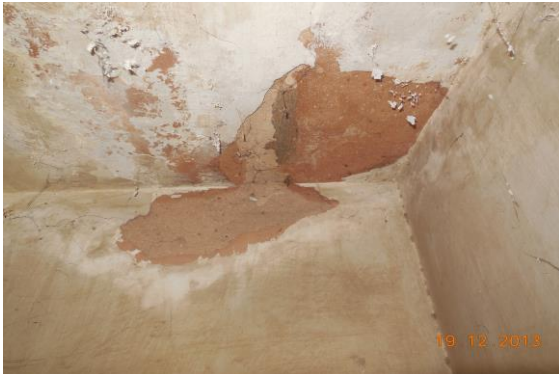
Photo 189
Peeling of Plaster on Roof & 4 of Staircase of First Floor

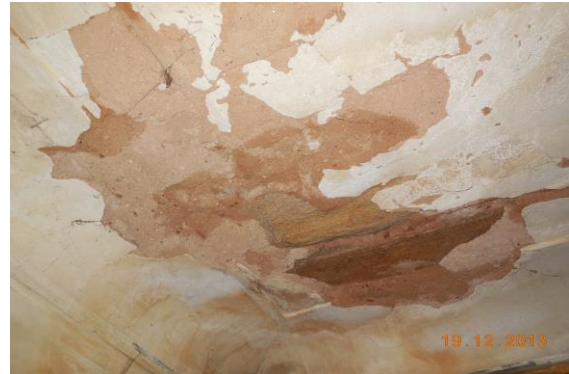
Photo 190
Damaged Portion on Roof of Gallery No.2 of First Floor

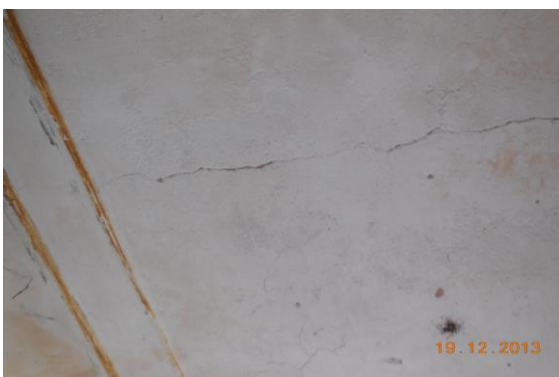
Photo 191
Plaster Crack on Roof of Gallery No.3 of First Floor

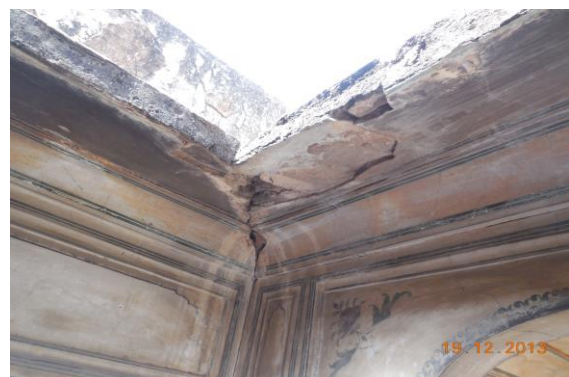
Photo 192
Damaged Portion on Sun Shade of Open Sky of First Floor

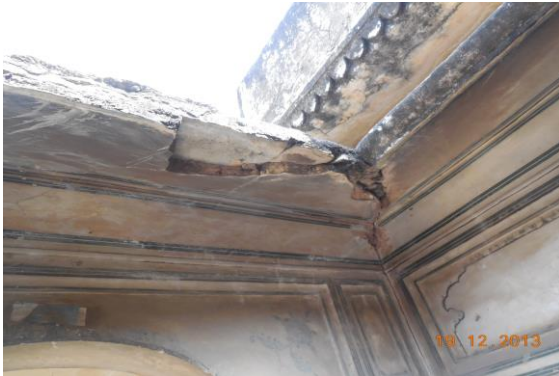
Photo 193
Damaged Portion on Sun Shade of Open Sky of First Floor

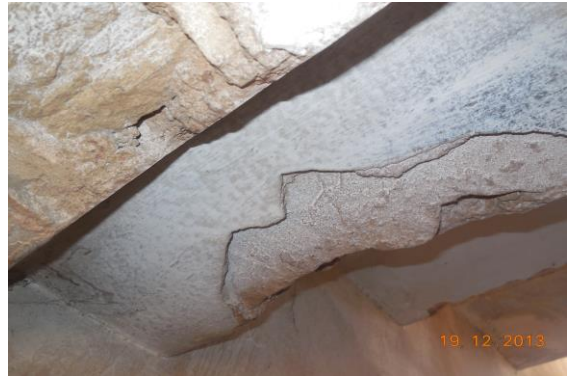
Photo 194
Damaged Portion on Roof of Staircase of First Floor

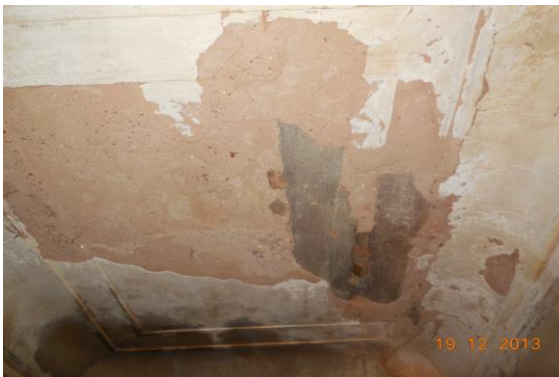
Photo 195
Damaged Portion on Roof of Gallery No.2 of First Floor

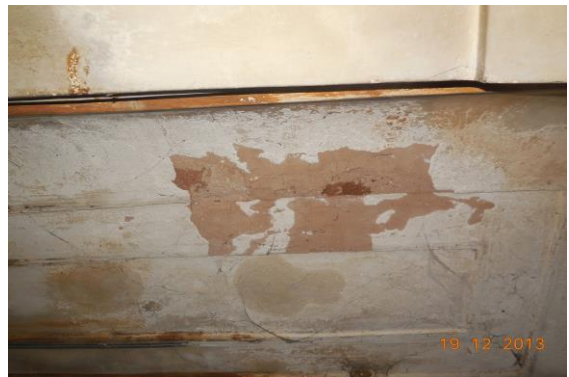
Photo 196
Damaged Portion on Roof of Gallery No.2 of First Floor

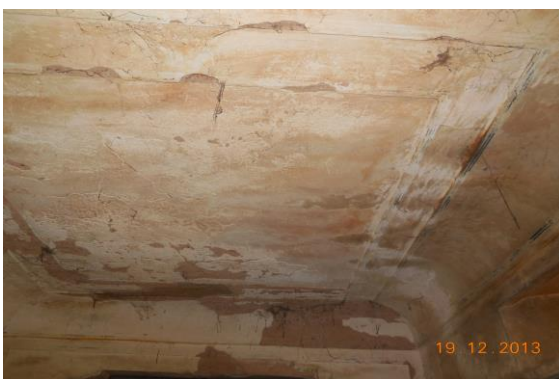
Photo 197
Damaged Portion on Roof of Gallery No.2 of First Floor

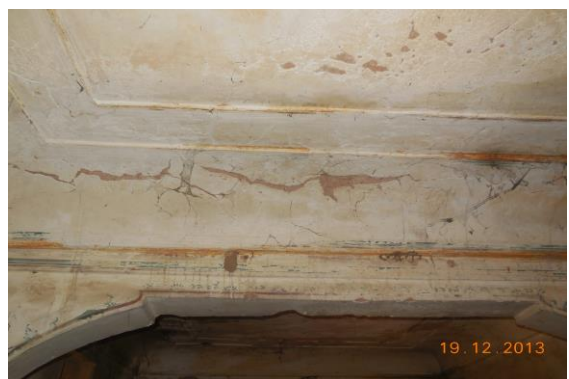
Photo 198
Damaged Portion on Roof of Gallery No.2 of First Floor

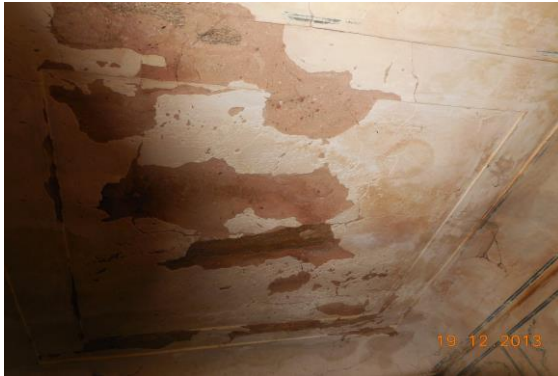
Photo 199
Damaged Portion on Roof of Gallery No.2 of First Floor

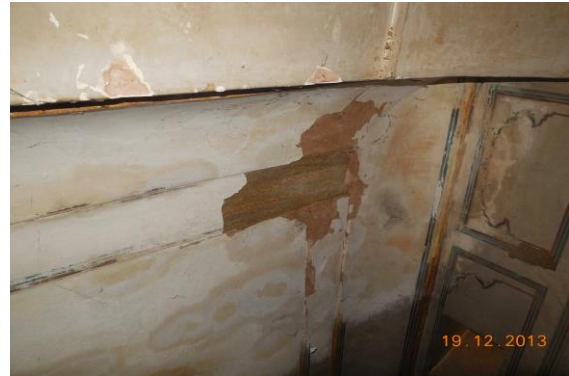
Photo 200
Damaged Portion on Roof of Gallery No.2 of First Floor

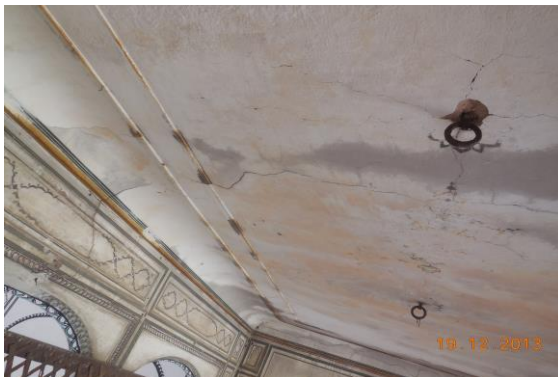
Photo 201
Damaged Portion on Roof of Varanda No.1 of First Floor

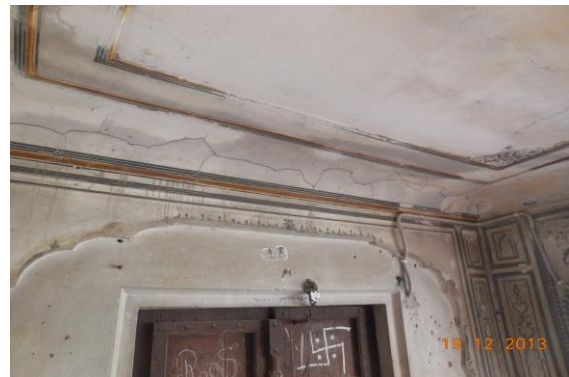
Photo 202
Damaged Portion on Roof of Varanda No.1 of First Floor

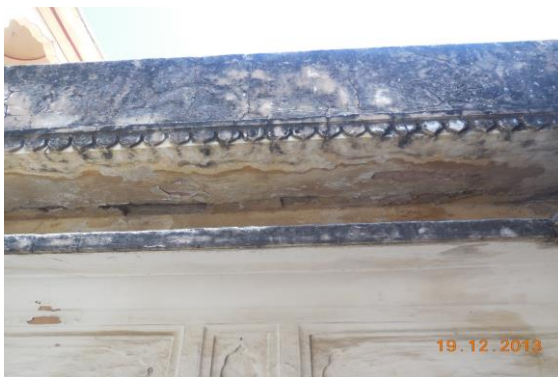
Photo 203
Damaged Portion on Shade of Open Sky of First Floor

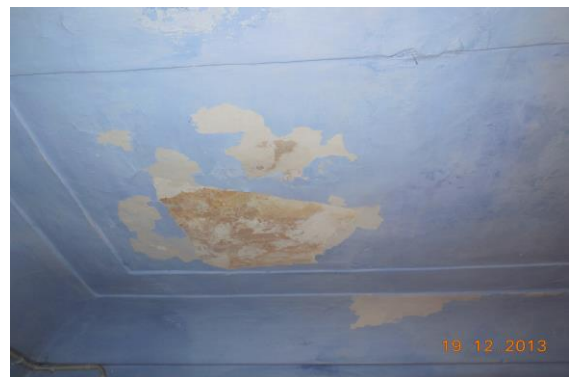
Photo 204
Peeling of Plaster on Roof of Room No. 13 of School, First Floor

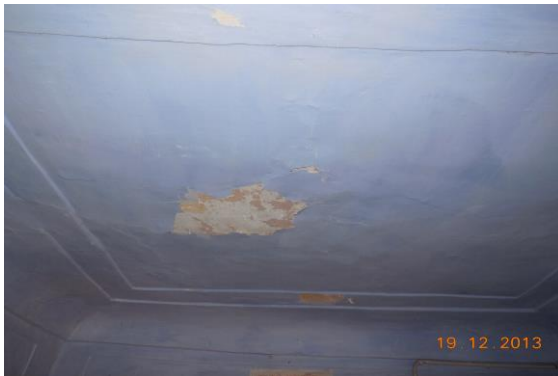
Photo 205

Peeling of Plaster on Roof of Room No. 13 of School, First Floor

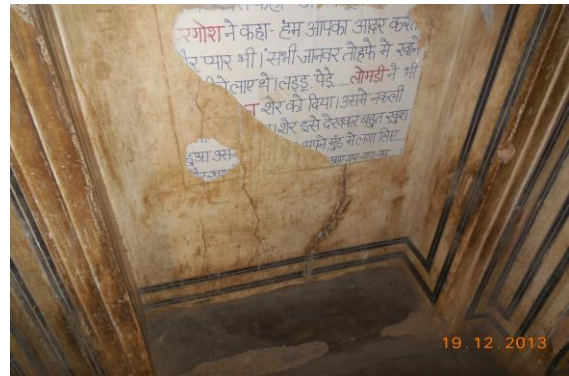
Photo 206

Plaster Crack on Wall No. 1 of Room No. 13 of School, First Floor

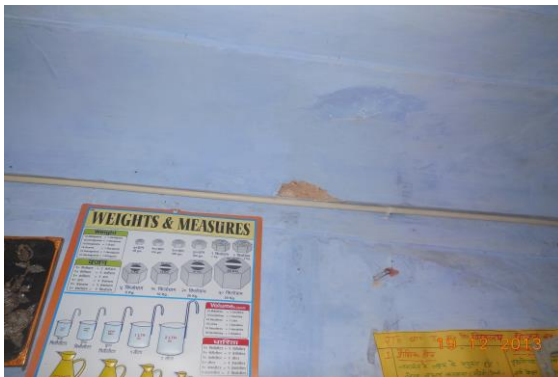
Photo 207

Damaged Portion on Wall No. 3 of Office Hall School of First Floor

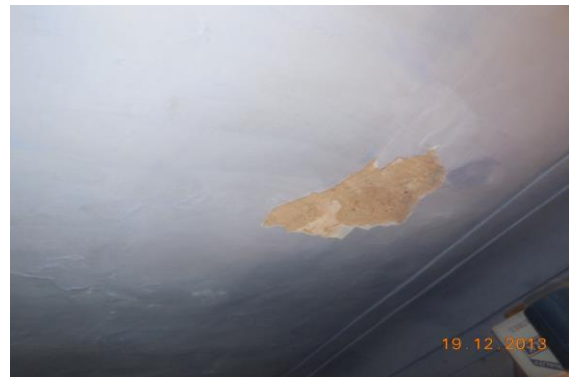
Photo 208

Damaged Portion on Roof of Office Hall School of First Floor

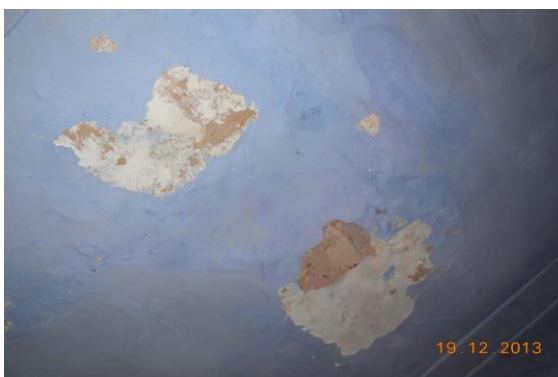
Photo 209

Damaged Portion on Roof of Office Hall School of

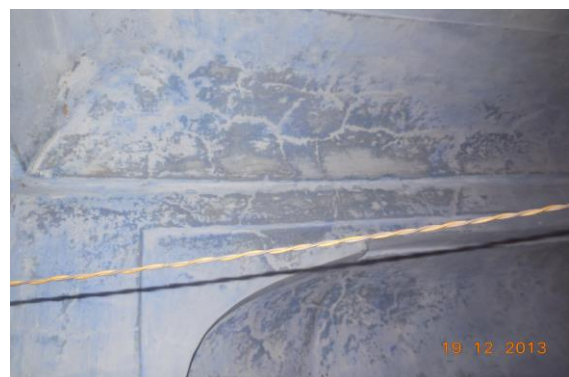
Photo 210

Damaged Portion on Wall No. 1 & Roof of Office Hall School of First Floor

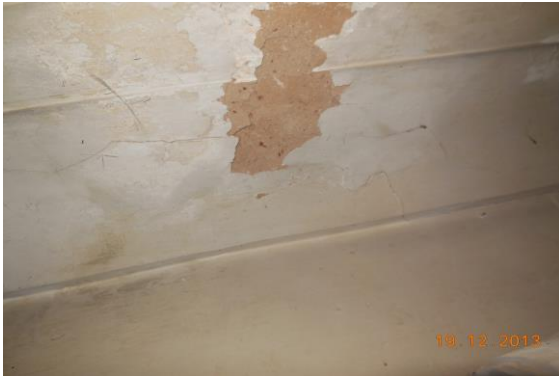
Photo 211

Dampness/Seepage on Wall No. 4 & Roof of Office Hall School of First Floor

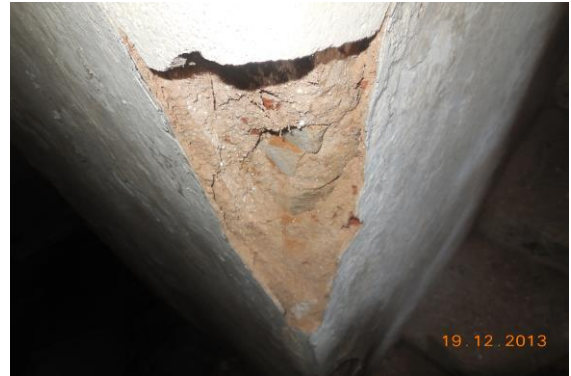
Photo 212

Damaged Portion on Wall No. 1 of Staircase Area of First Floor

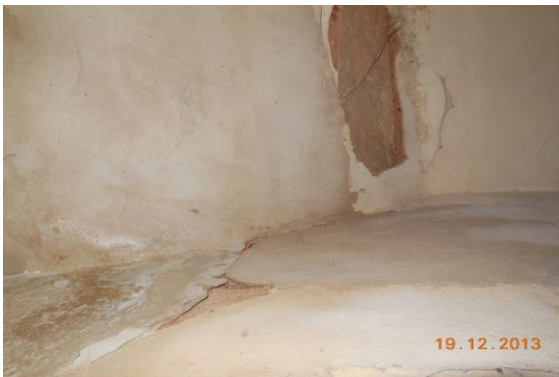
Photo 213

Damaged Portion on Roof of Staircase Area of First Floor

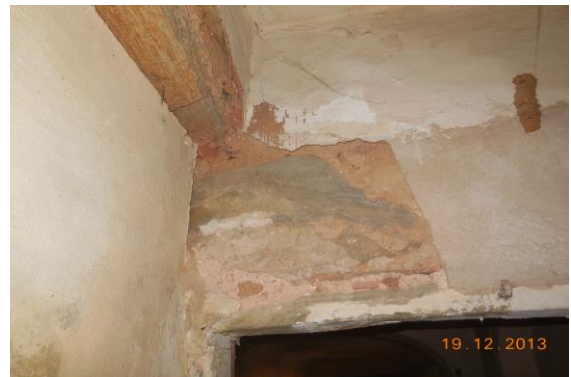
Photo 214

Damaged Portion on Wall No. 4 of Staircase Area of First Floor

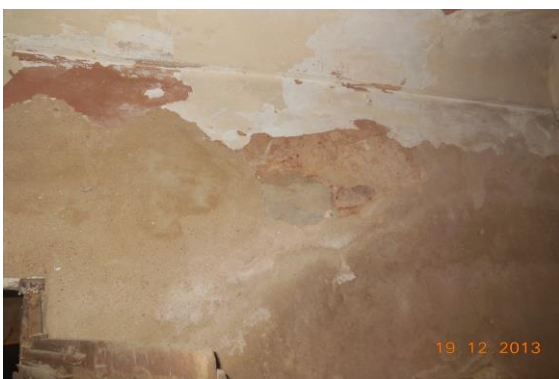
Photo 215

Damaged Portion on Wall No. 3 of Staircase Area of First Floor

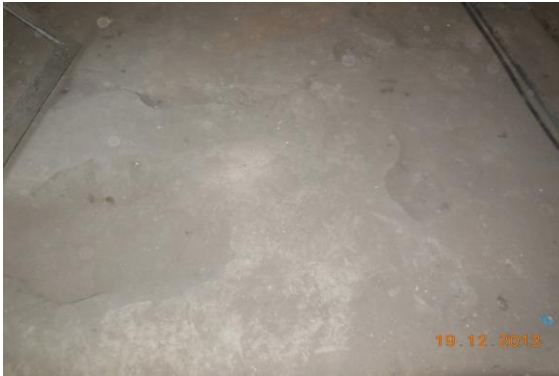
Photo 217
Damaged Portion on Floor of Staircase Area of First Floor

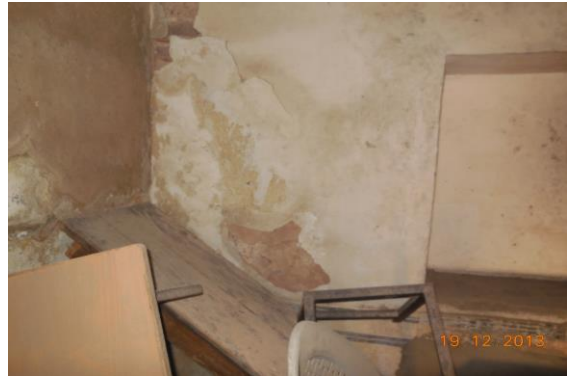
Photo 218
Damaged Portion on Wall No. 1 of Hall No. 1 of School, First Floor

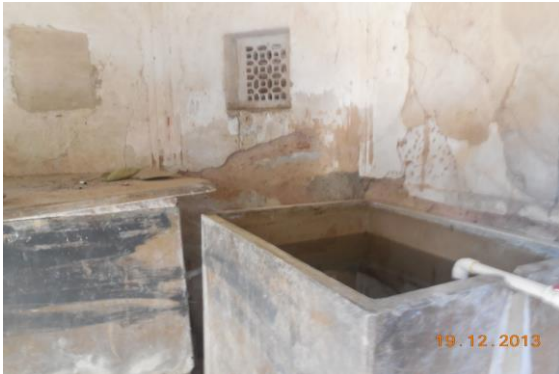
Photo 219
Damaged Portion on All walls of Tomb No.1 of First Floor

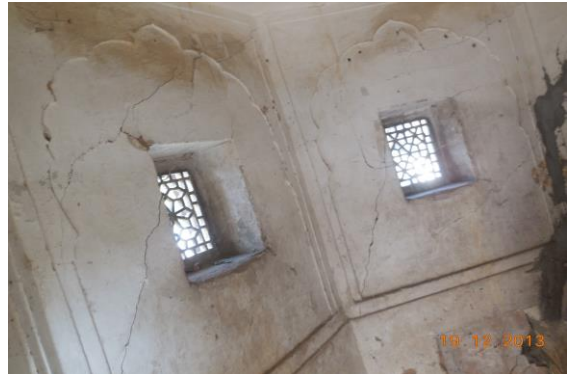
Photo 220
Damaged Portion on All walls of Tomb No.1 of First Floor

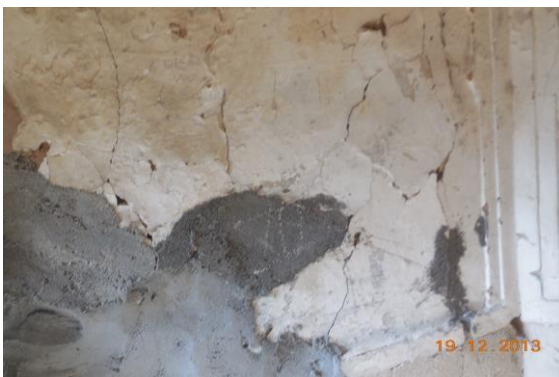
Photo 221
Damaged Portion on All walls of Tomb No.1 of First Floor

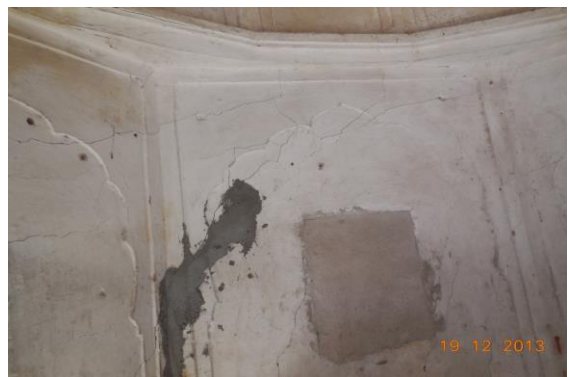
Photo 222
Damaged Portion on All walls of Tomb No.1 of First Floor

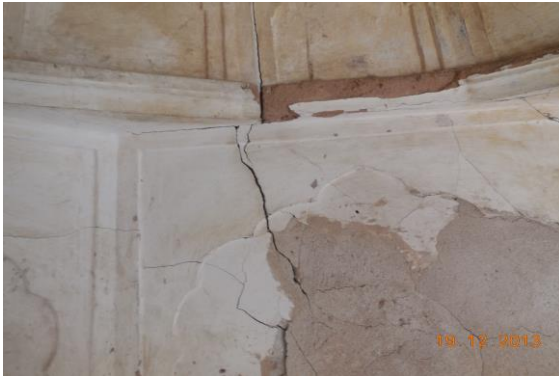
Photo 223
Damaged Portion on All walls of Tomb No.1 of First Floor

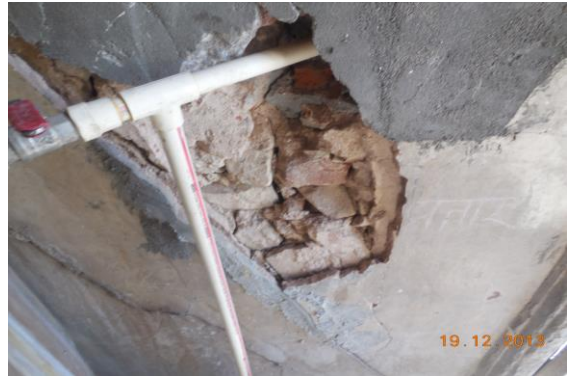
Photo 224
Damaged Portion on All walls of Tomb No.1 of First Floor

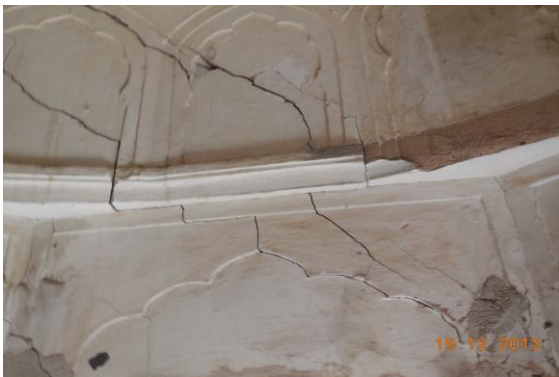
Photo 225
Damaged Portion on All walls of Tomb No.1 of First Floor
