Pre Building Condition Survey Report

Name and Address of Structure :	Choti Chopar to Badi Chopar (UP Line)
---------------------------------	---------------------------------------

Name of the Project	Contract JMRC-UG1B “Design and Construction of Tunnel between Chandpole and Badi Chouper and reverse line by Shield TBM, Underground Metro Stations at Choti Chouper and Badi Chouper by Cut and Cover Methods on East West Corridor of Jaipur Metro Rail Corporation Limited .”	
Owner :

Shoping Complex - Shop No. 169-188
Tripolia Bazar
Jaipur
Unique ID: CC BC UP 0001

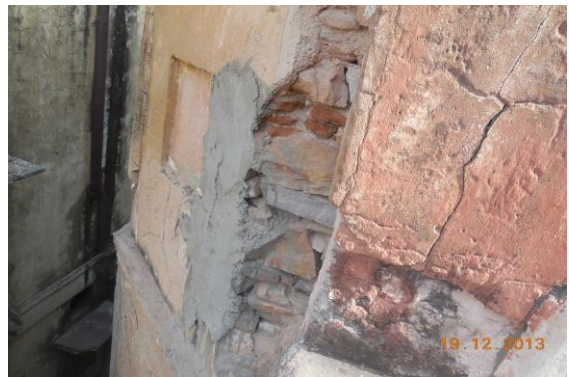
Photo 226
Damaged Portion on Outer Wall of Tomb No.1 of First Floor

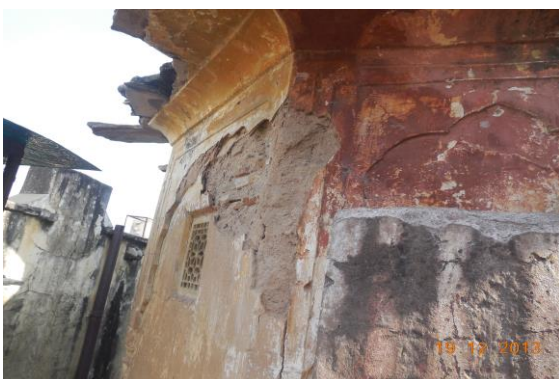
Photo 227
Damaged Portion on Outer Wall of Tomb No.1 of First Floor

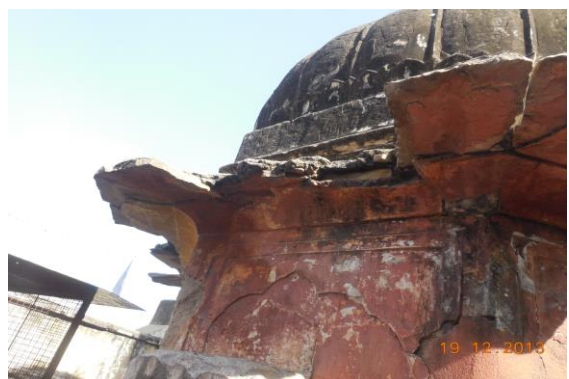
Photo 228
Damaged Portion on Sun Shade of Tomb No.1 of First Floor

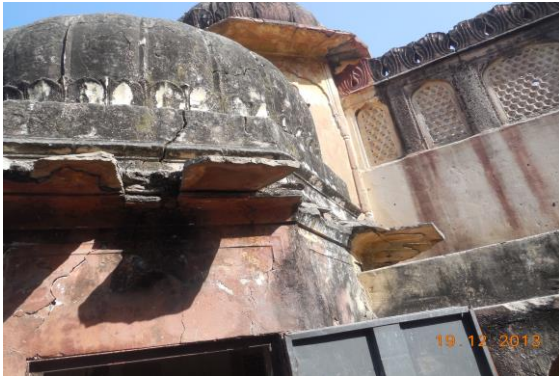
Photo 229
Damaged Portion on Sun Shade of Tomb No.1 of First Floor

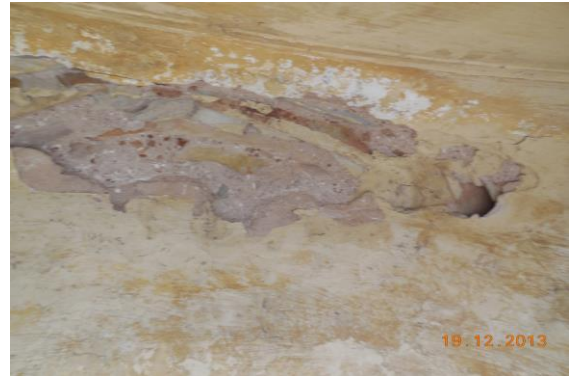
Photo 230
Damaged Portion on Roof of Minarates No.3 of First Floor

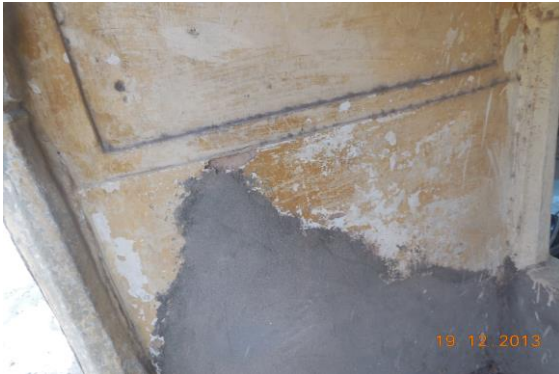
Photo 231
Peeling of Plaster on Wall No. 1 of Minarates No.3 of First Floor

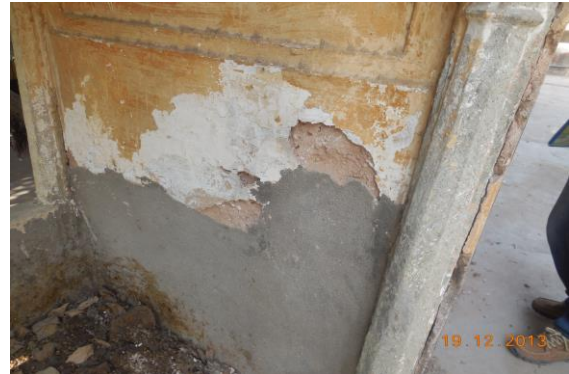
Photo 232
Peeling of Plaster on Wall No. 1 of Minarates No.3 of First Floor

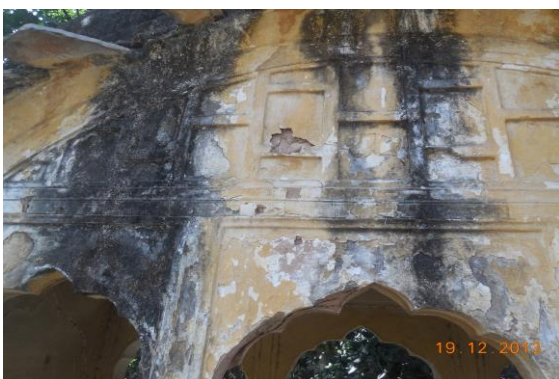
Photo 233
Peeling of Plaster on Outer Wall of Minarates No.3 of First Floor

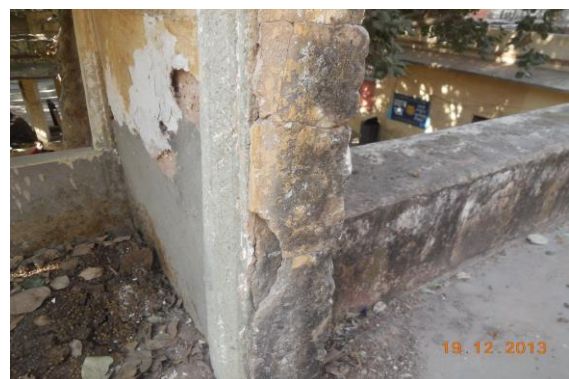
Photo 234
Peeling of Plaster on Outer Wall of Minarates No.3 of First Floor

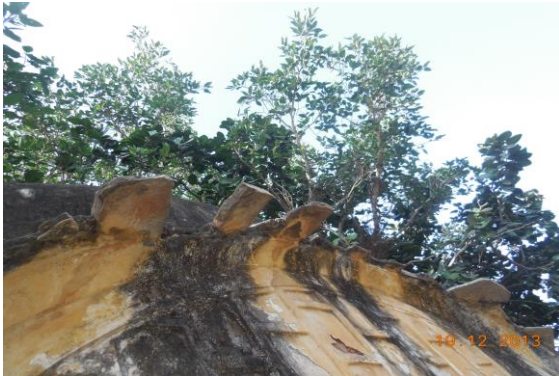
Photo 235
Damaged Portion on Sun Shade of Minarates No.3 of First Floor

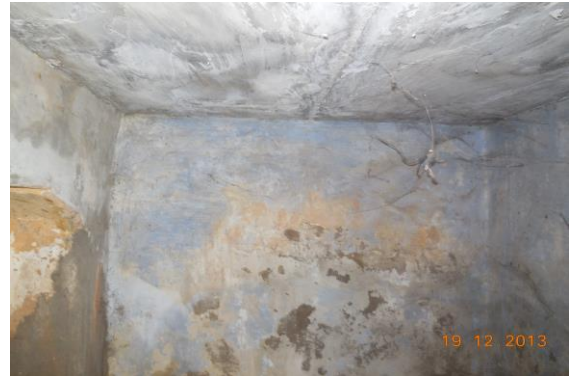
Photo 236
Dampness/Seepage on All walls of Toilet No. 1 of School, First Floor

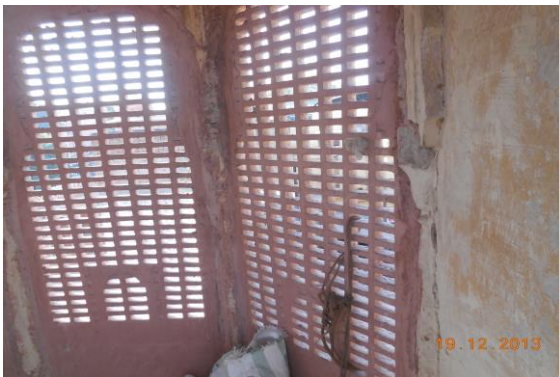
Photo 237
Peeling of Plaster on All walls of Tomb No.1 of Terrace

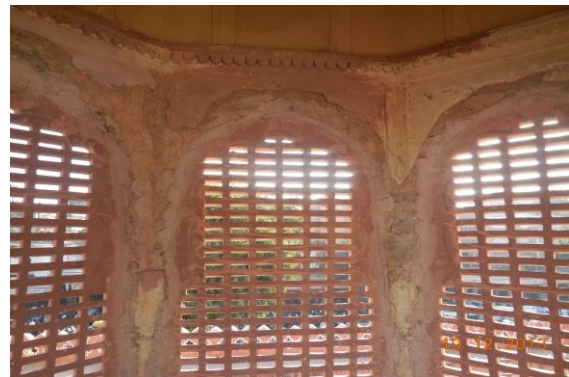
Photo 238
Peeling of Plaster on All walls of Tomb No.2 of Terrace

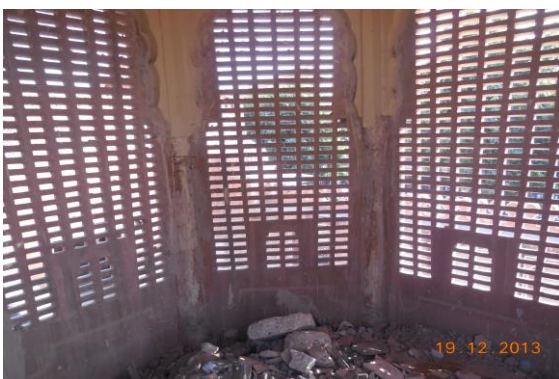
Photo 239
Peeling of Plaster on All walls of Tomb No.3 of Terrace

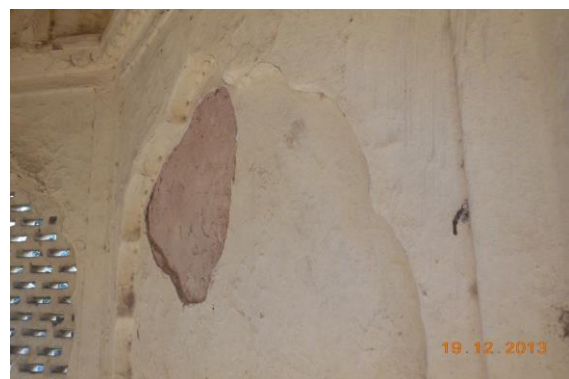
Photo 240
Peeling of Plaster on All walls & Roof of Tomb No.4 of Terrace

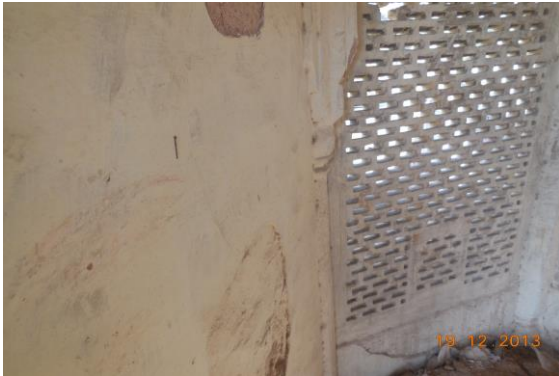
Photo 241
Peeling of Plaster on All walls & Roof of Tomb No.4 of Terrace

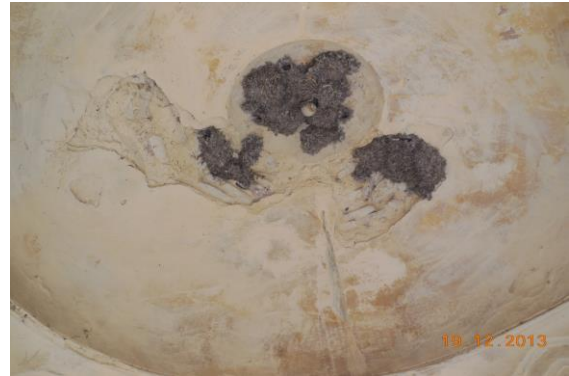
Photo 242
Peeling of Plaster on All walls & Roof of Tomb No.4 of Terrace

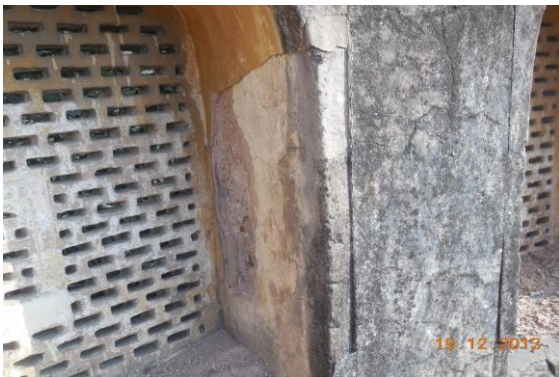
Photo 243
Peeling of Plaster on Wall No. 4 of School of Terrace

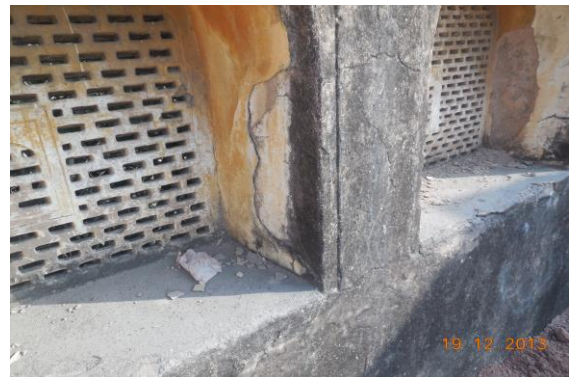
Photo 244
Peeling of Plaster on Wall No. 4 of School of Terrace

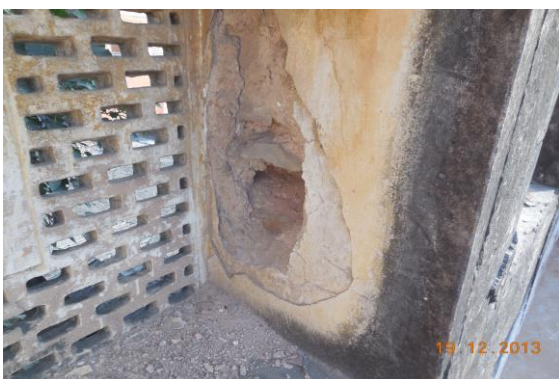
Photo 245
Peeling of Plaster on Wall No. 4 of School of Terrace

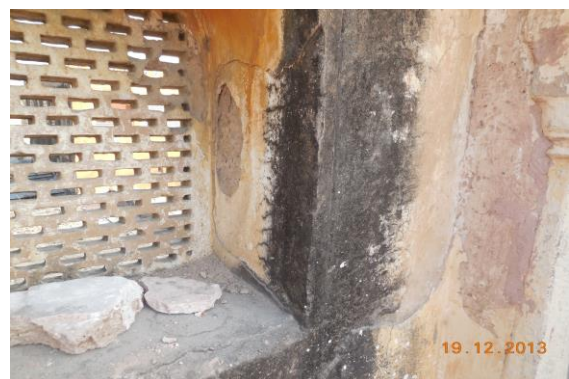
Photo 246
Peeling of Plaster on Wall No. 4 of School of Terrace

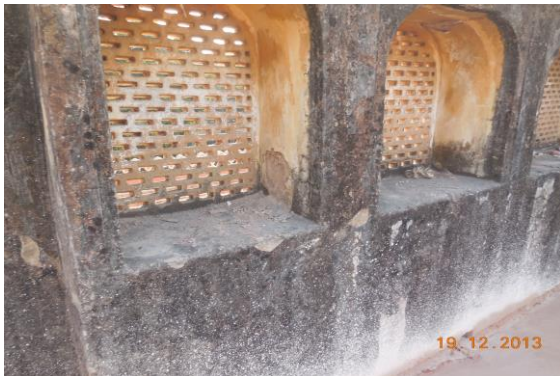
Photo 247
Peeling of Plaster on Wall No. 1 of School of Terrace

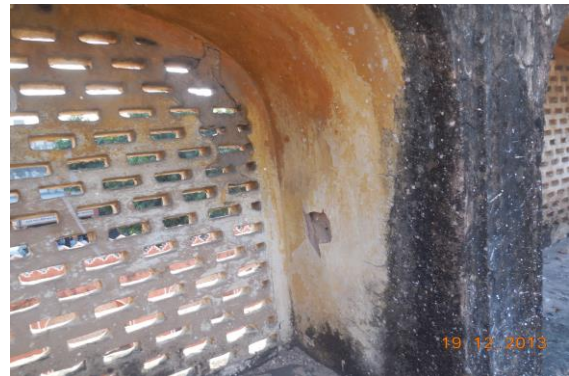
Photo 248
Peeling of Plaster on Wall No. 1 of School of Terrace

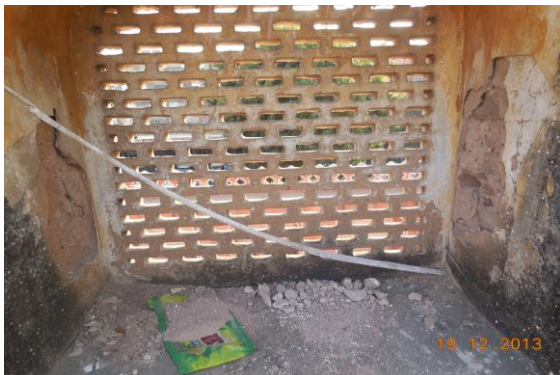
Photo 249
Peeling of Plaster on Wall No. 1 of School of Terrace

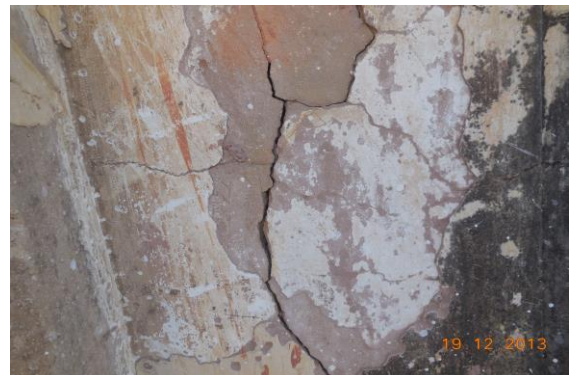
Photo 250
Damaged Portion on Wall No. 2 of School of Terrace

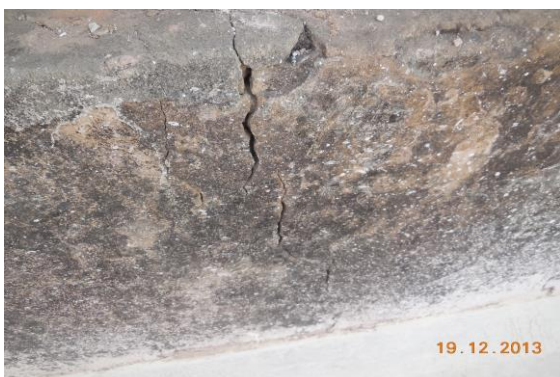
Photo 251
Damaged Portion on Wall No. 3 of School of Terrace

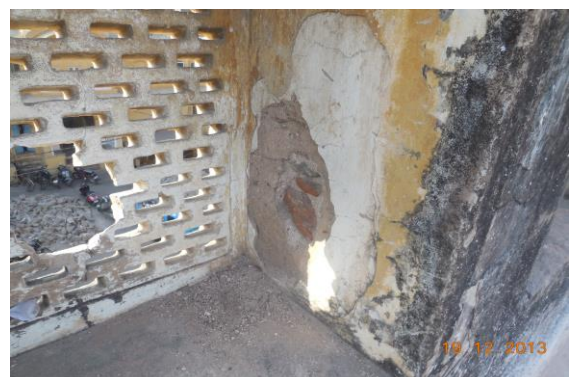
Photo 252
Peeling of Plaster on Wall No. 3 of School of Terrace

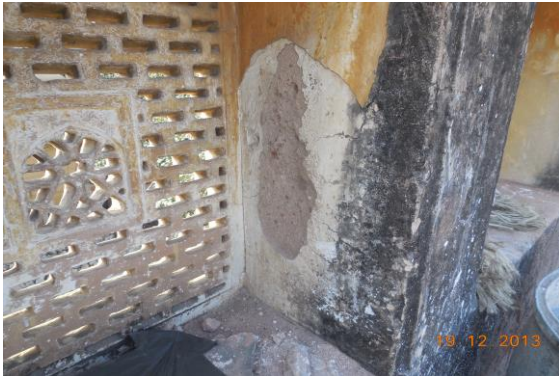
Photo 253
Peeling of Plaster on Wall No. 3 of School of Terrace

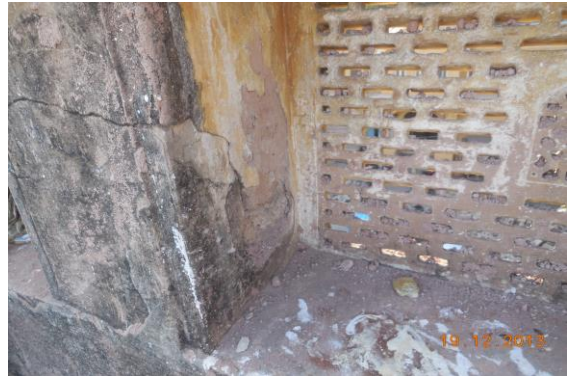
Photo 254
Peeling of Plaster on Wall No. 3 of School of Terrace

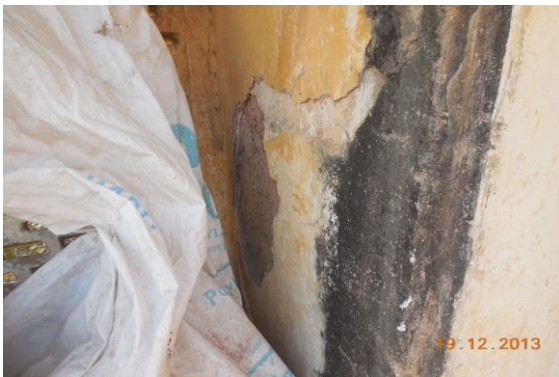
Photo 255
Peeling of Plaster on Wall No. 3 of School of Terrace

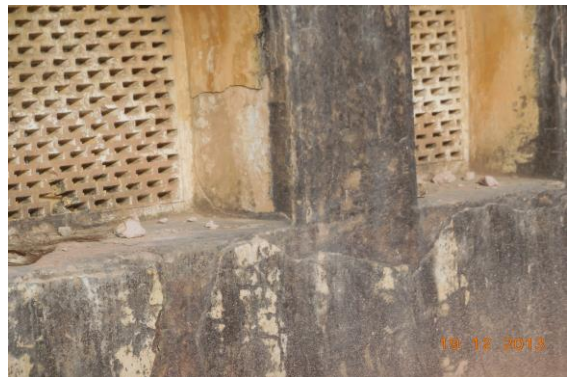
Photo 256
Peeling of Plaster on Wall No. 2 of School of Terrace

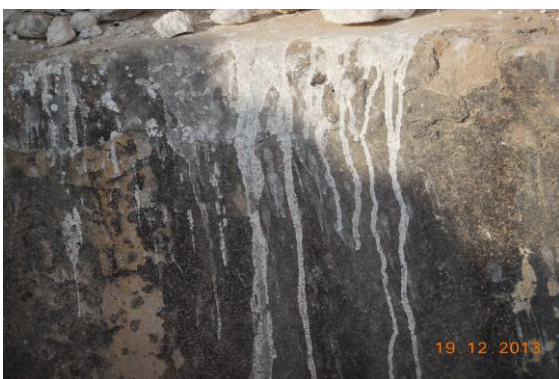
Photo 257
Peeling of Plaster on Wall No. 2 of School of Terrace

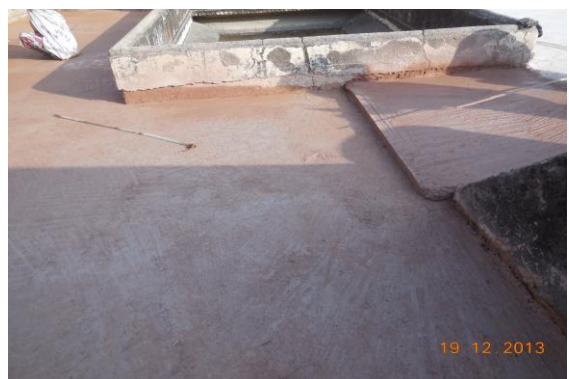
Photo 258
Peeling of Plaster on Floor of School of Terrace

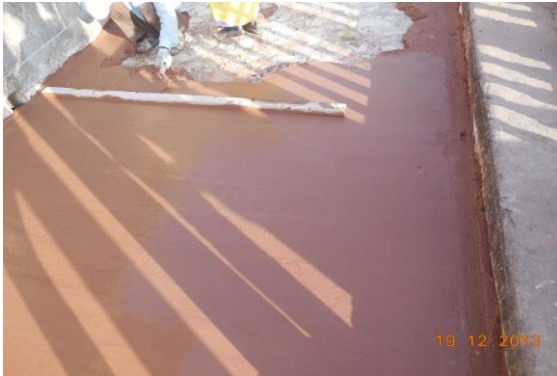
Photo 259
Peeling of Plaster on Floor of School of Terrace

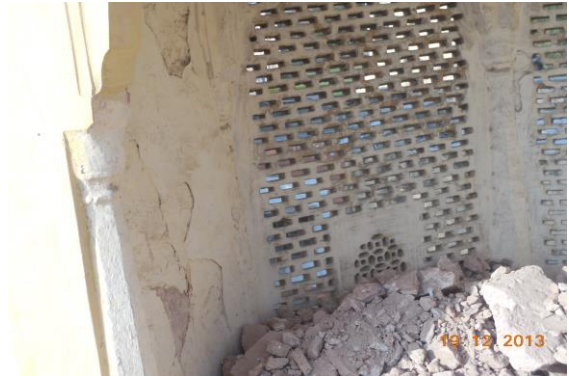
Photo 260
Peeling of Plaster on All walls & Roof of Tomb No.5 of Terrace

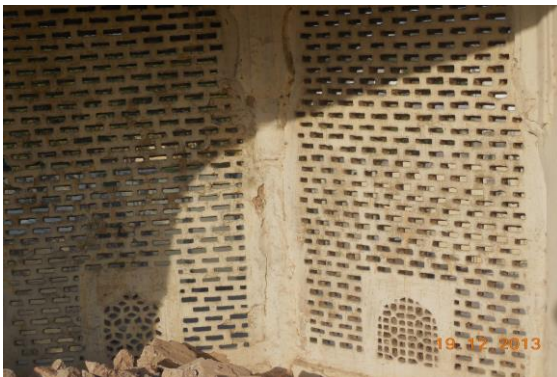
Photo 261
Peeling of Plaster on All walls & Roof of Tomb No.5 of Terrace

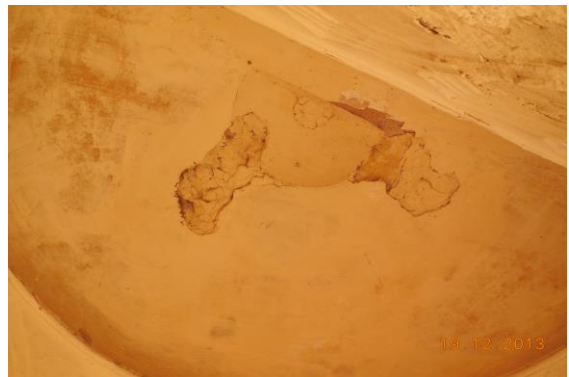
Photo 262
Peeling of Plaster on All walls & Roof of Tomb No.5 of Terrace

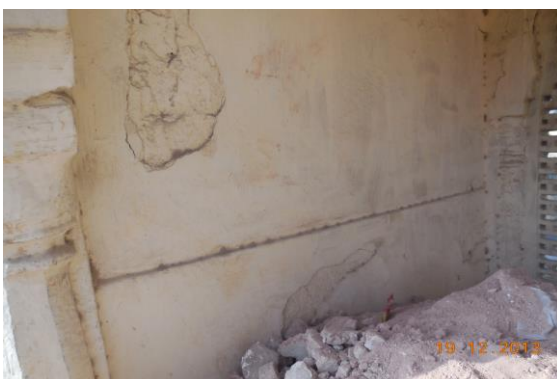
Photo 263
Peeling of Plaster on Wall No. 1 of Minarates No.8 of Terrace

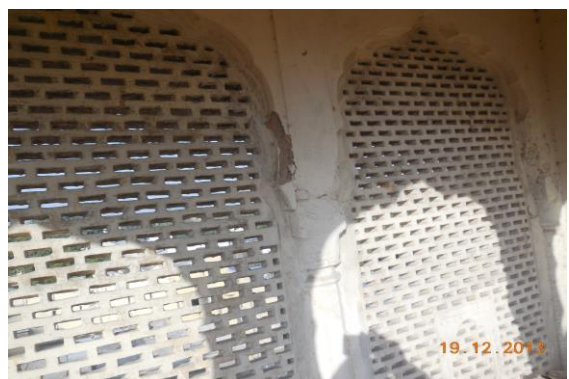
Photo 264
Peeling of Plaster on Wall No. 4 of Minarates No.8 of Terrace

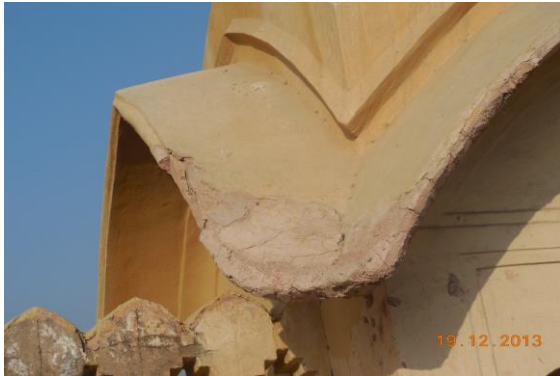
Photo 265
Damaged Portion on Roof Shade of Minarates No.8 of Terrace

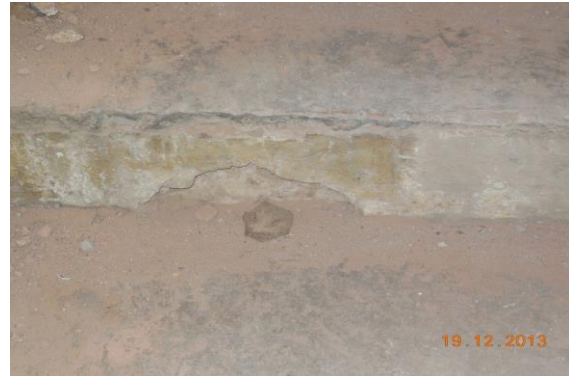
Photo 266
Peeling of Plaster on of staircase First Floor To Terrace of

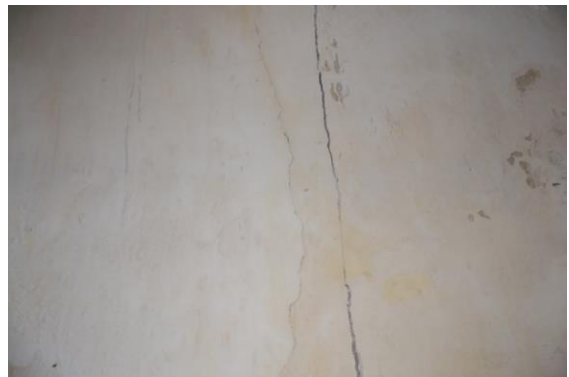
Photo 4
Inclined Crack on Wall No. 4 of Room No. 3, Hall No. 1, Ground Floor
Approx. Width = 5mm, Approx. Length = 3m.

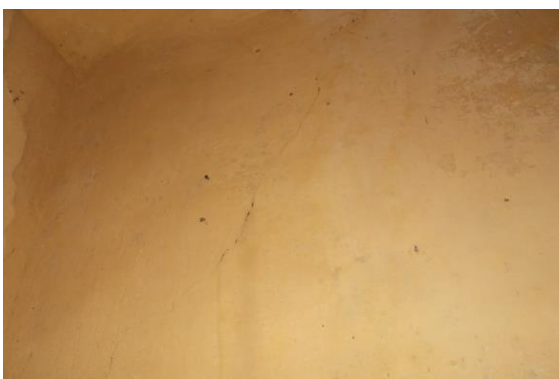
Photo 5
Inclined Crack on Wall No. 2 of Room No. 3, Hall No. 1, Ground Floor
Approx. Width = 0.5mm, Approx. Length = 2m.

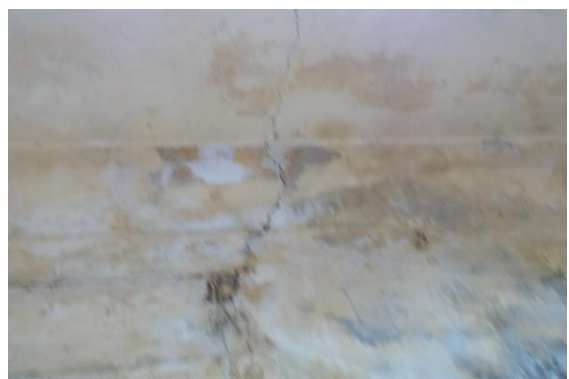
Photo 6
Inclined Crack on Wall No. 2 of Open Area, Ground Floor
Approx. Width = 1mm, Approx. Length = 1m.
Distance from Wall no.3 = 5m, Height from Floor = 2.5m.

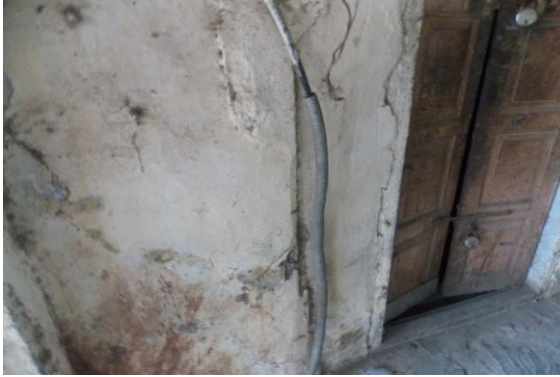
Photo 7
Inclined Crack on Wall No. 1 of Entry passage, Ground Floor
Approx. Width = 5mm, Approx. Length = 2m.

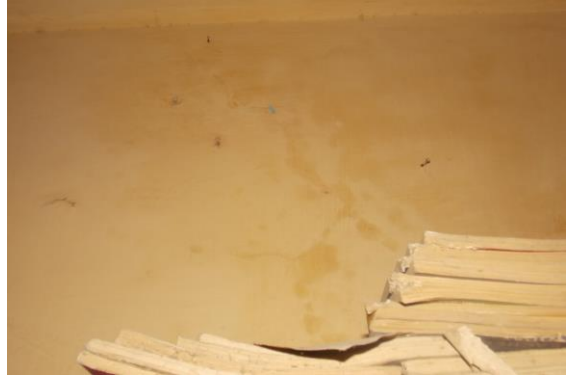
Photo 8
Dampness/Seepage on Wall No. 5 of Room No. 2 of Ground Floor

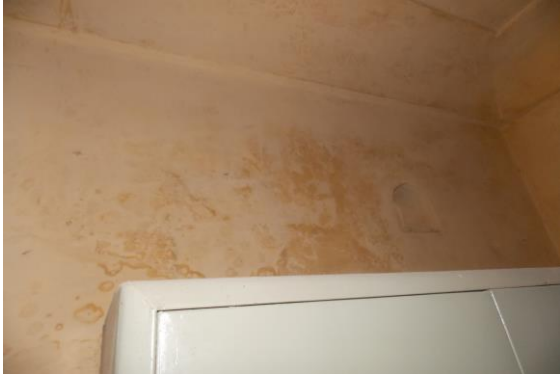
Photo 9
Dampness/Seepage on Wall No. 6 of Room No. 2 of Ground Floor

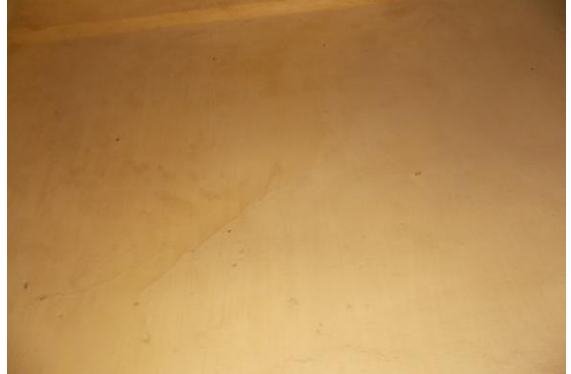
Photo 10
Dampness/Seepage on Wall No. 2 of Room No. 2 of Ground Floor

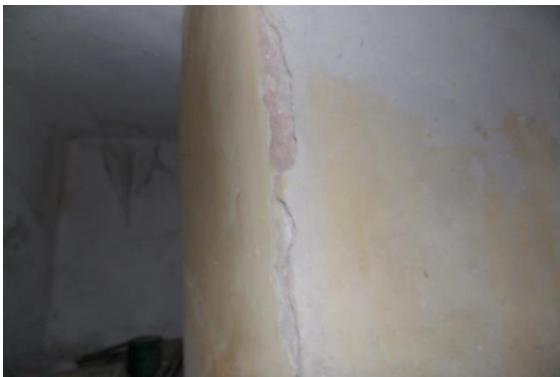
Photo 11
Dampness/Seepage on Wall No. 4 & Roof of Store of Ground Floor

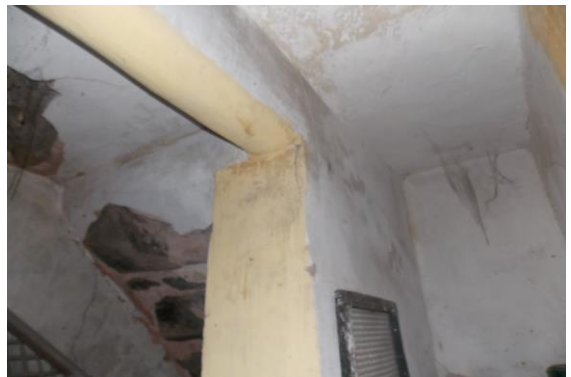
Photo 12
Dampness/Seepage on Wall No. 4 & Roof of Store of Ground Floor

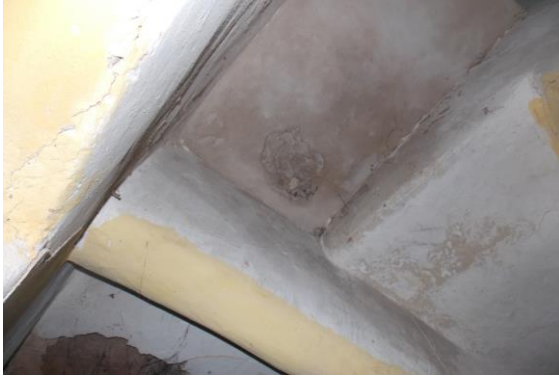
Photo 13
Dampness/Seepage on Roof of Store of Ground Floor

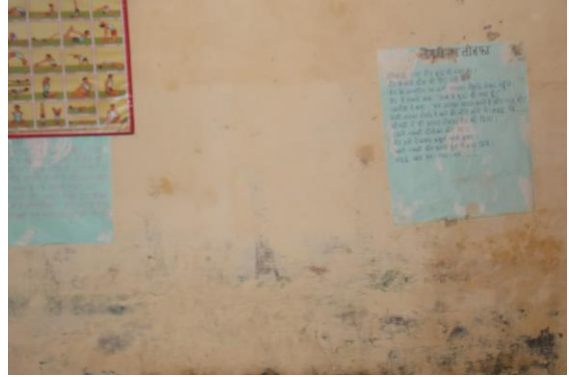
Photo 14
Dampness/Seepage on Wall No. 1 of Room No. 1 of Ground Floor

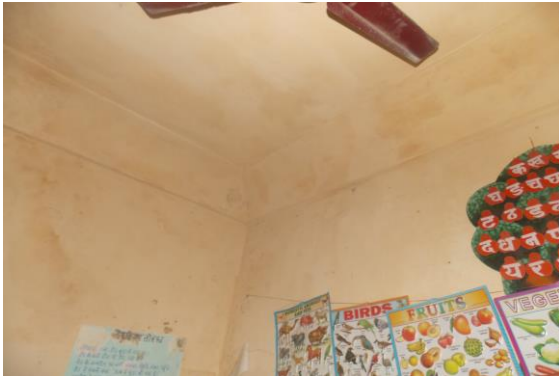
Photo 15
Dampness/Seepage on Wall No. 1, 4 & Roof of Room No. 1 of Ground Floor

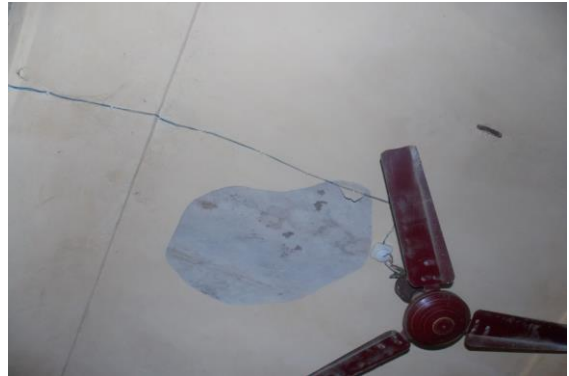
Photo 16
Dampness/Seepage on Roof of Room No. 1 of Ground Floor

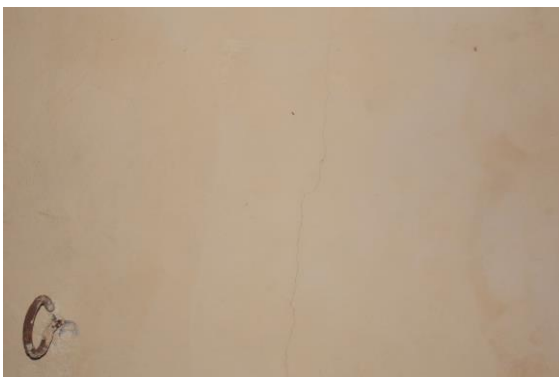
Photo 17
Peeling of Plaster on Roof of Room No. 1 of Ground Floor

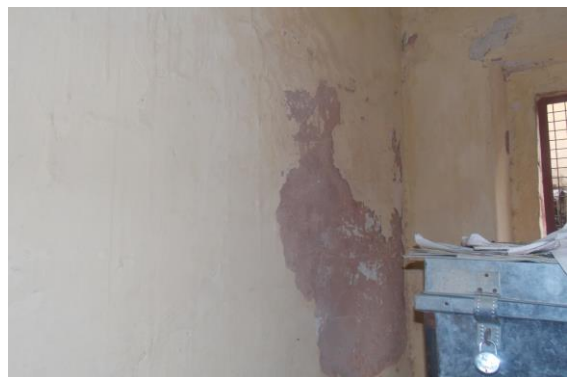
Photo 18
Dampness/Seepage on Wall No. 5 of Room No. 1 of Ground Floor

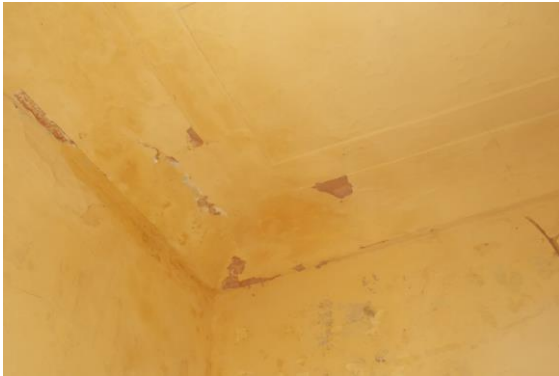
Photo 19

Dampness/Seepage on Wall No. 6 & Roof of Room No. 1 of Ground Floor

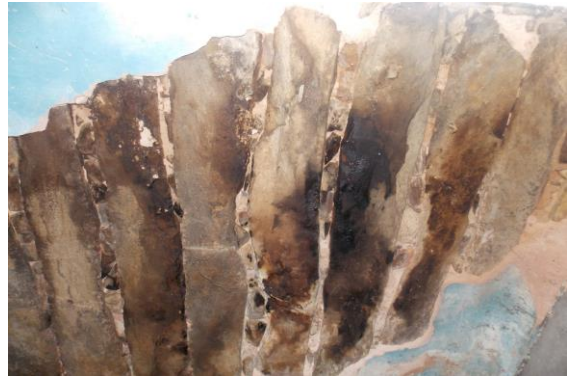
Photo 20

Peeling of Plaster on Roof of Room No. 6 of Ground Floor

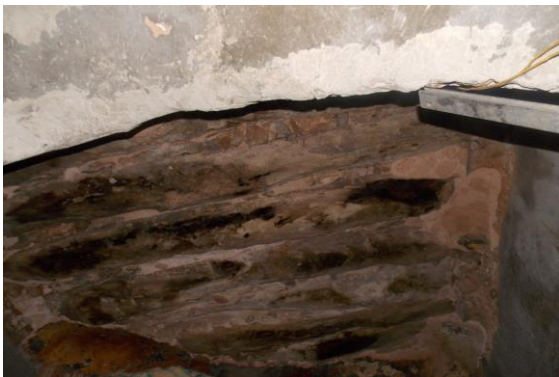
Photo 21

Peeling of Plaster on Roof of Room No. 6 of Ground Floor

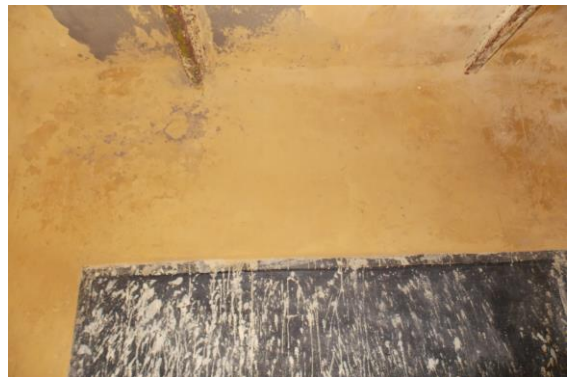
Photo 22

Dampness/Seepage on Wall No. 1 of Room No. 3 of Hall No. 1, Ground Floor

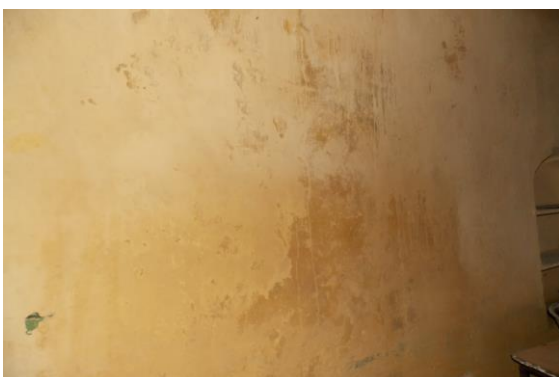
Photo 23

Dampness/Seepage on Wall No. 4 of Room No. 3 of Hall No. 1, Ground Floor

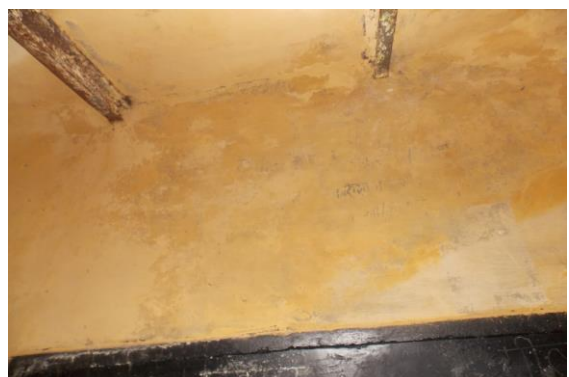
Photo 24

Dampness/Seepage on Wall No. 2 of Room No. 3 of Hall No. 1, Ground Floor

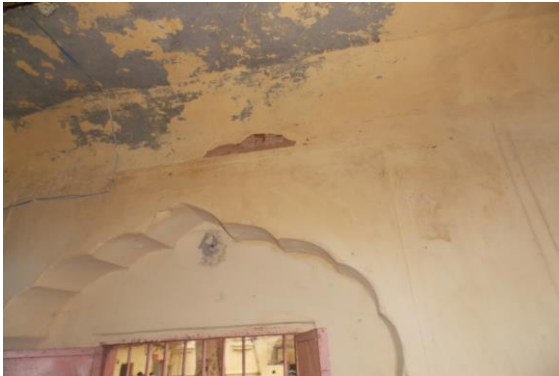
Photo 25

Dampness/Seepage on Wall No. 3 of Room No. 3 of Hall No. 1, Ground Floor

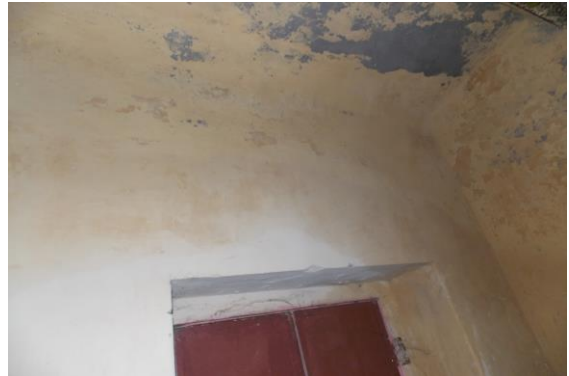
Photo 26

Dampness/Seepage on Wall No. 3 of Room No. 3 of Hall No. 1, Ground Floor

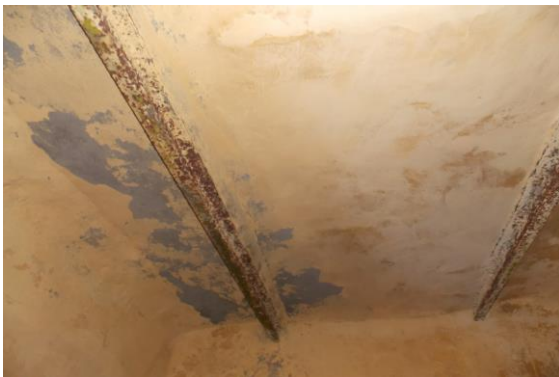
Photo 27

Dampness/Seepage on Roof of Room No. 3 of Hall No. 1, Ground Floor

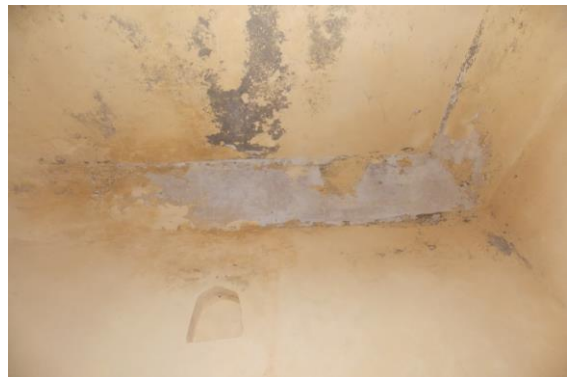
Photo 28

Dampness/Seepage on Wall No. 4 & Roof of Room No. 5 of Ground Floor

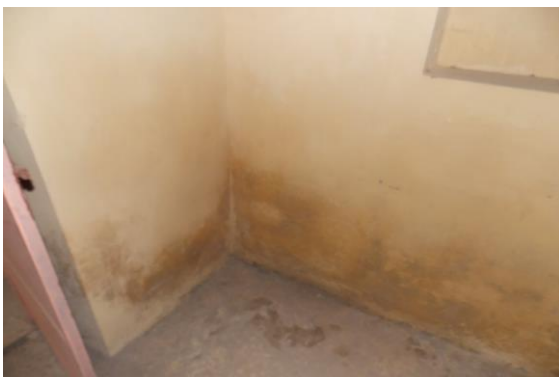
Photo 29

Dampness/Seepage on Wall No. 1 & 3 of Room No. 5 of Ground Floor

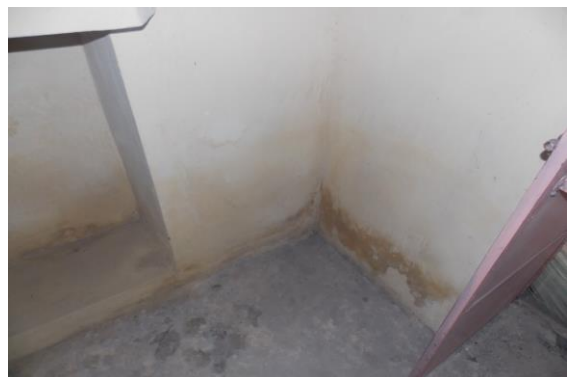
Photo 30

Dampness/Seepage on Wall No. 2 & 3 of Room No. 5 of Ground Floor

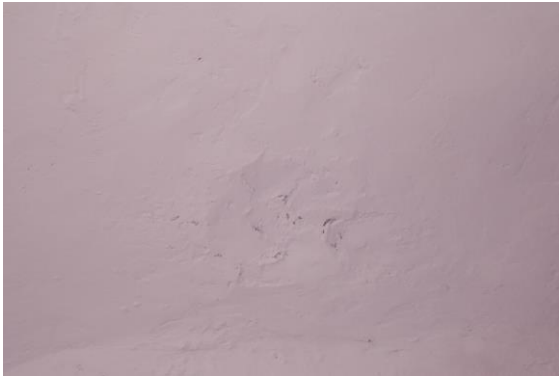
Photo 31

Peeling of Plaster on Roof of Room No. 9 of Ground Floor

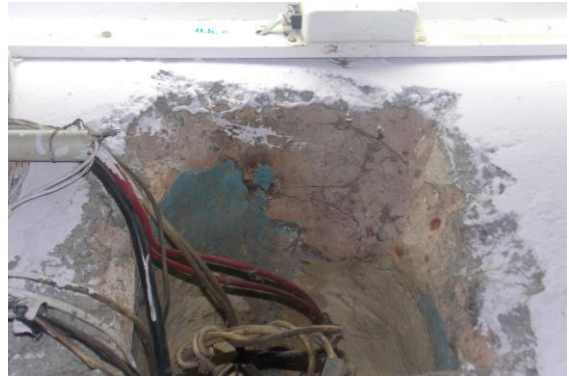
Photo 32

Damaged Portion on Wall No. 3 & Roof of Room No. 9 of Ground Floor

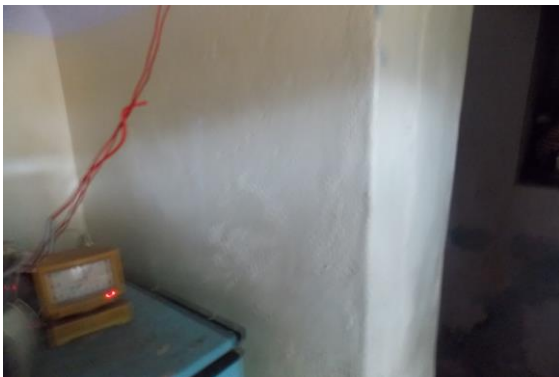
Photo 33

Dampness/Seepage on Wall No. 2 of Room No. 11 of Ground Floor

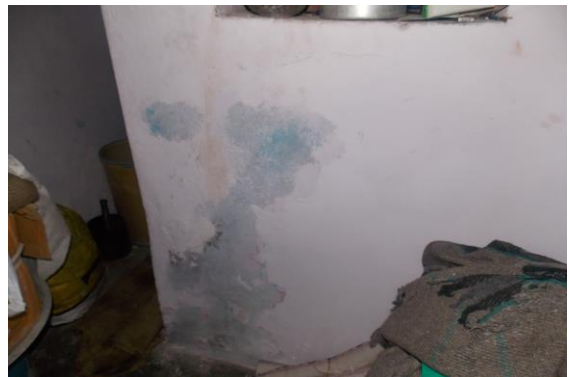
Photo 34

Dampness/Seepage on Wall No. 4 of Store no.2 of Ground Floor

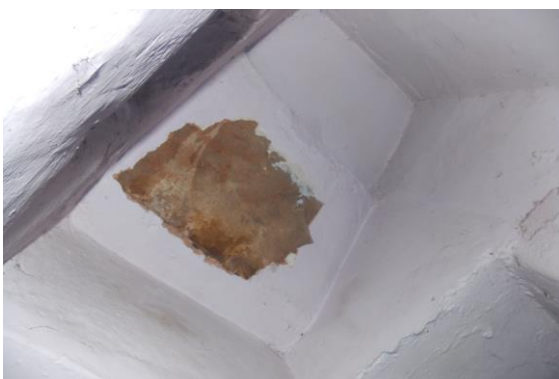
Photo 35

Peeling of Plaster on Roof of Store No.2 of Ground Floor

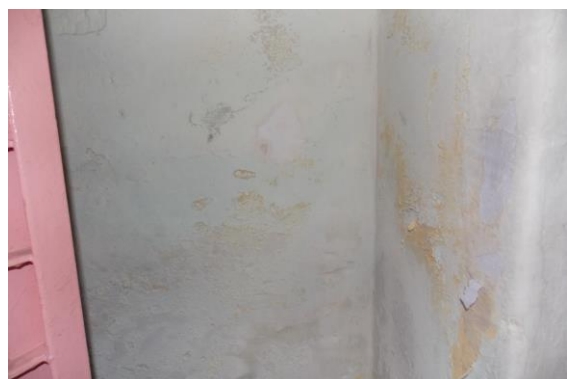
Photo 36

Dampness/Seepage on Wall No. 4 & 2 of Staircase of Ground Floor

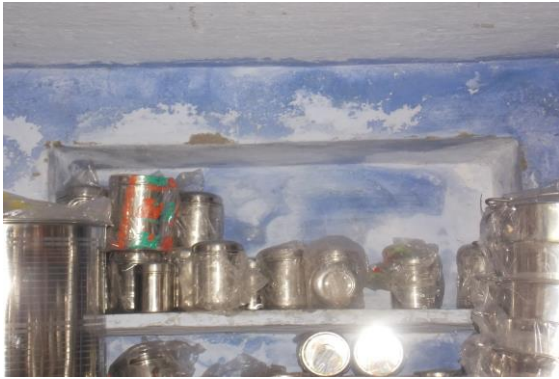
Photo 37

Dampness/Seepage on Wall No. 4 of Room No. 13 of Ground Floor

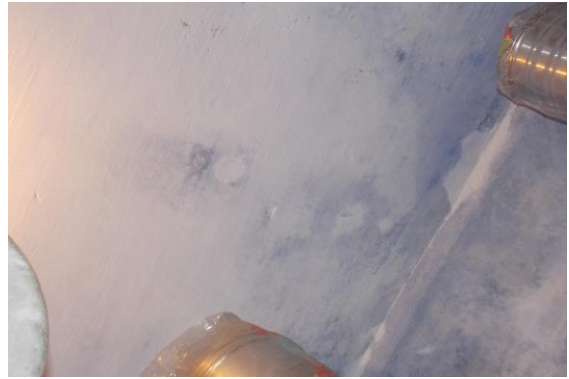
Photo 38

Dampness/Seepage on Roof of Room No. 13 of Ground Floor

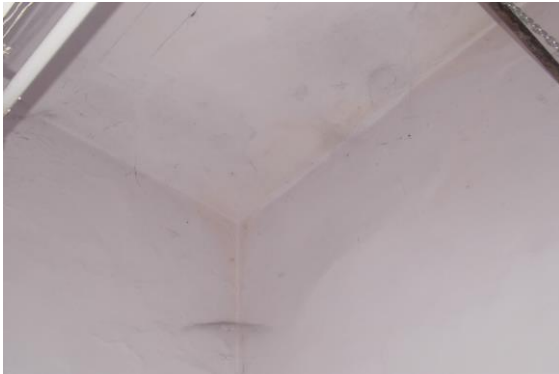
Photo 39

Dampness/Seepage on Wall No. 1, 4 & Roof of Temple of Ground Floor

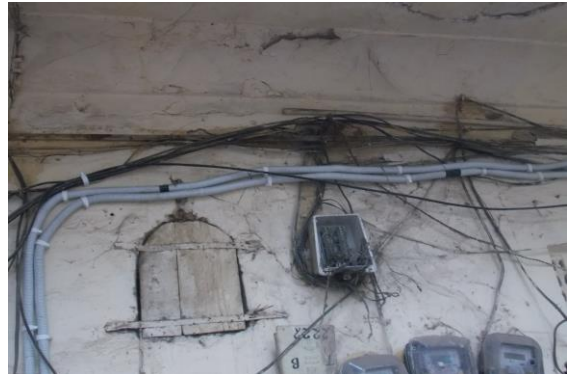
Photo 40

Dampness/Seepage on Wall No. 3 of Open Area of Ground Floor

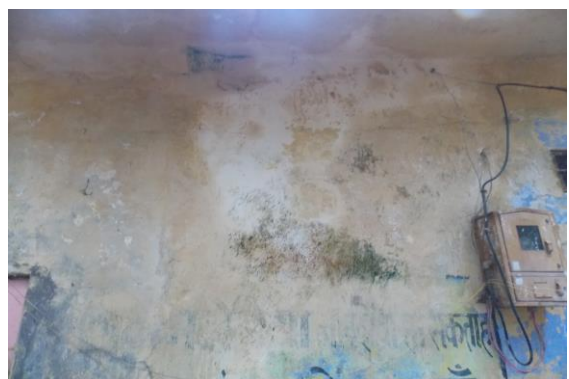
Photo 42

Dampness/Seepage on Wall No. 2 of Open Area of Ground Floor

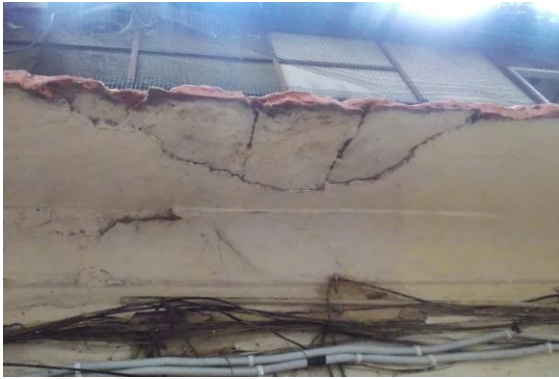
Photo 43

Damaged Portion on Wall No. 3 & sunshade of Open Area of Ground Floor

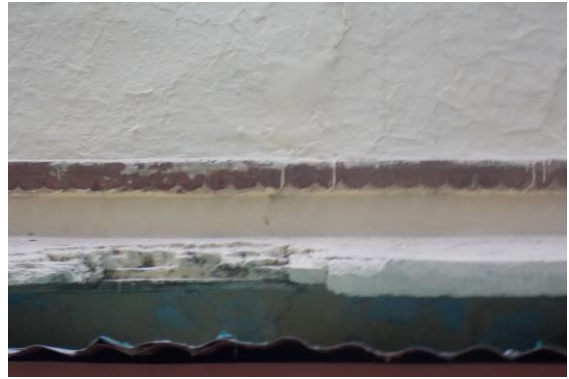
Photo 44

Peeling of Plaster on Wall No. 4 & sunshade of Open Area of Ground Floor

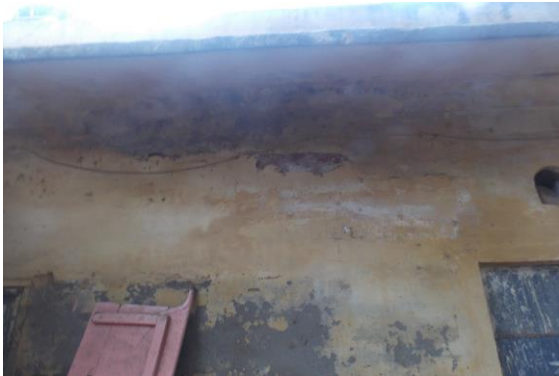
Photo 45

Dampness/Seepage on Wall No. 2 of Open Area of Ground Floor

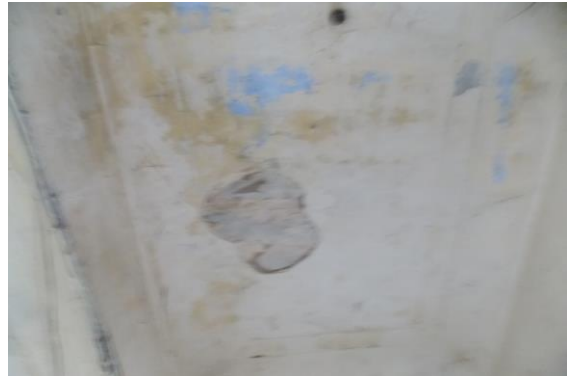
Photo 46

Dampness/Seepage on Roof of Entry passage of Ground Floor

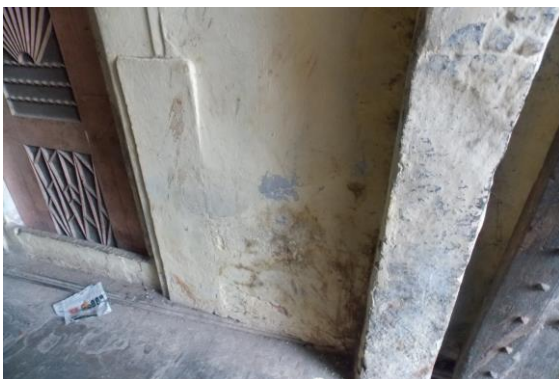
Photo 47

Dampness/Seepage on Wall No. 2 of Entry passage of Ground Floor

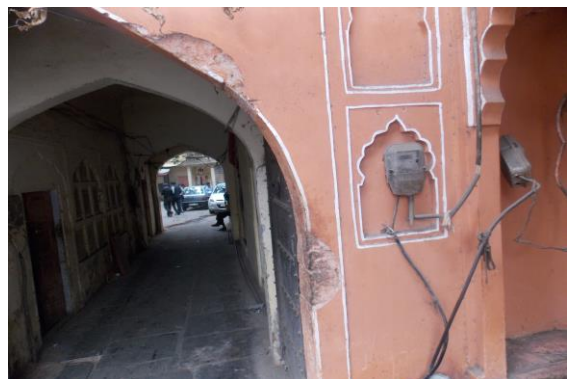
Photo 48

Damaged Portion on Outer Wall Main Gate of of Ground Floor

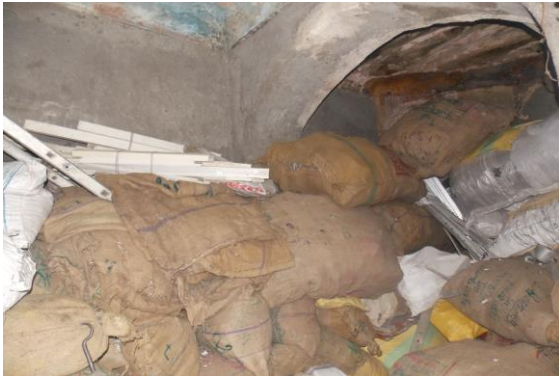
Photo 49

All walls of Room No. 6 of Ground Floor Covered with Material

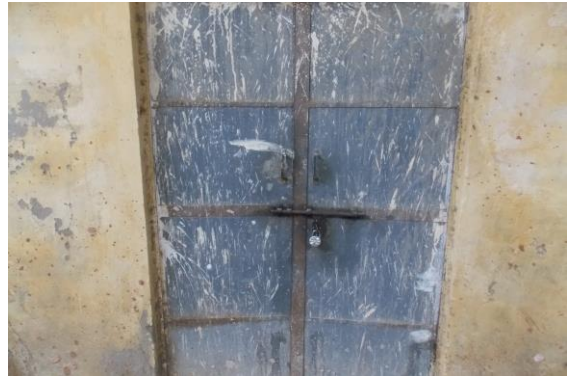
Photo 50

Toilet No. 1 of Ground Floor Locked

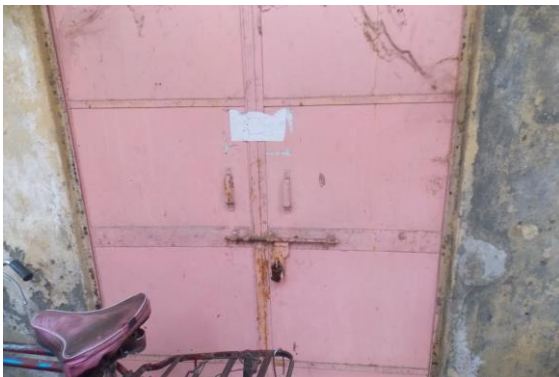
Photo 51

Room No. 4 of Ground Floor Locked

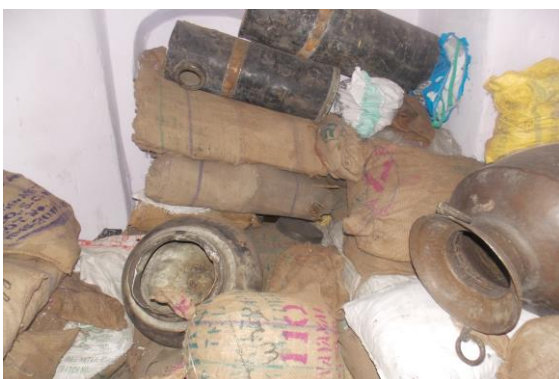
Photo 52

Room No. 8 of Ground Floor Locked

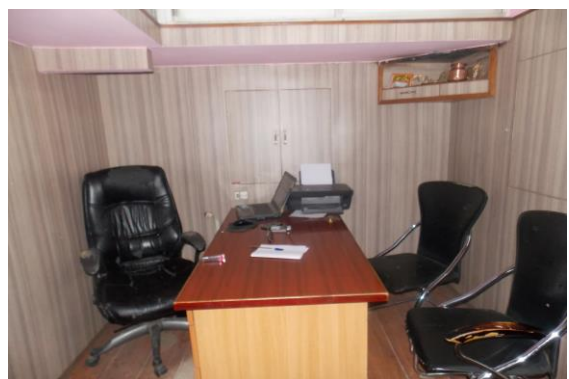
Photo 53

Wall No. 1 & 4 of Room No. 9 of Ground Floor Covered with material

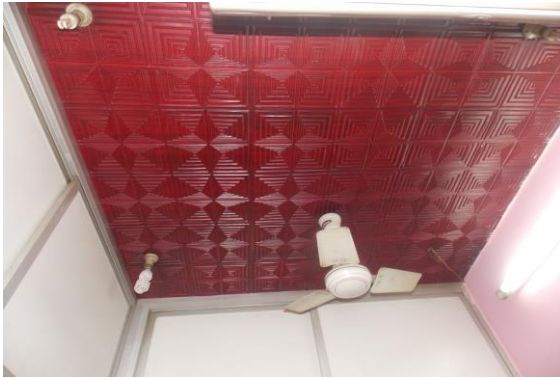
Photo 54

All walls of Room No. 10 of Ground Floor Covered with wooden works

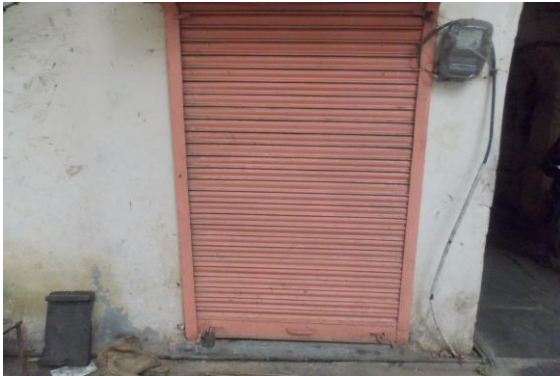
Photo 56

All walls of Room No. 13 of Ground Floor Covered with material

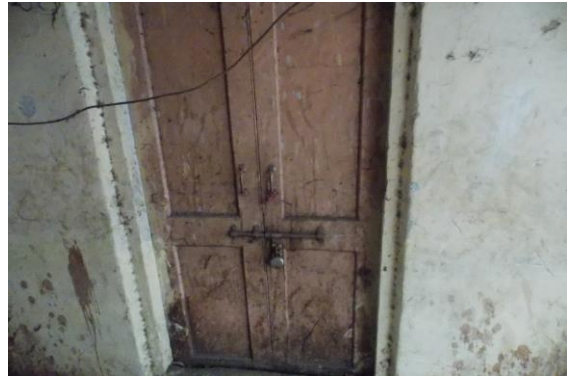
Photo 57

Room No. 14 of Ground Floor Locked

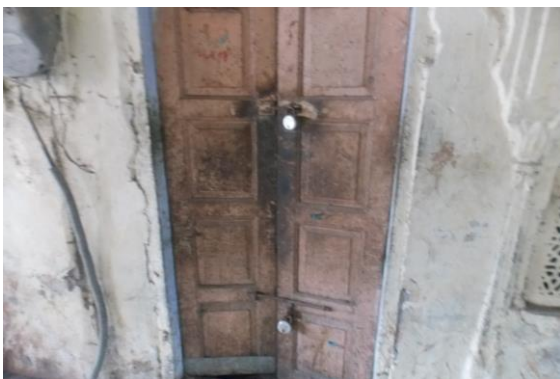
Photo 58

Room No. 16 of Ground Floor Locked

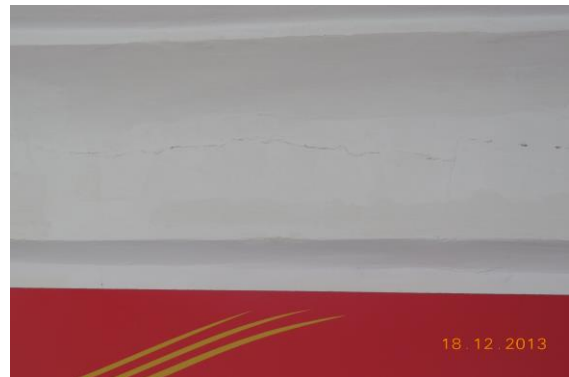
Photo 10
Horizontal Crack on Roof of Lobby of Post Office, Ground Floor
Approx. Width = 0.5mm, Approx. Length = 2m.

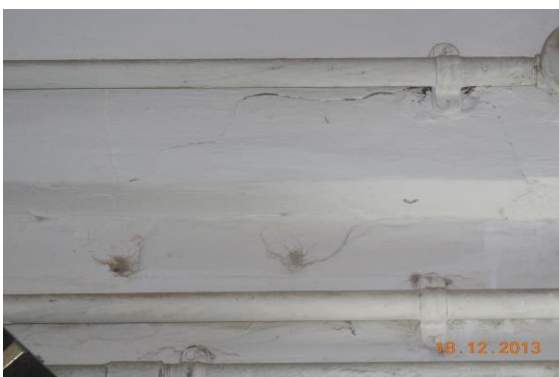
Photo 11
Inclined Crack on Roof of Hall No. 1, First Floor
Approx. Width = 1mm, Approx. Length = 2m.

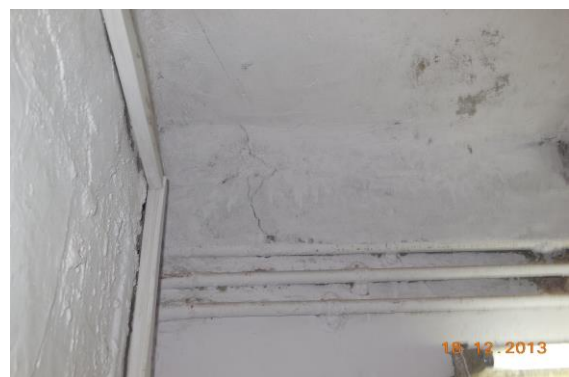
Photo 12
Inclined Crack on Wall No. 1 & Roof of Room No. Registry Room, First Floor
Approx. Width = 1mm, Approx. Length = 0.3m. Distance from Wall No.3 = 0.15m, Height from Floor = 2.1m.

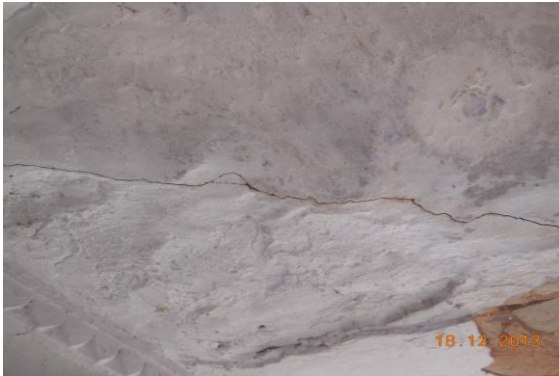
Photo 13

Horizontal Crack on Shade of Passage, First Floor
Approx. Width = 0.6mm, Approx. Length = 1m.
Height from Floor = 2.5m.
