Pre Building Condition Survey Report

Name and Address of Structure :	Choti Chopar to Badi Chopar (UP Line)
---------------------------------	---------------------------------------

Name of the Project	Contract JMRC-UG1B “Design and Construction of Tunnel between Chandpole and Badi Chouper and reverse line by Shield TBM, Underground Metro Stations at Choti Chouper and Badi Chouper by Cut and Cover Methods on East West Corridor of Jaipur Metro Rail Corporation Limited .”	
Owner :

Shoping Complex - Shop No. 169-188
Tripolia Bazar
Jaipur
Unique ID: CC BC UP 0001

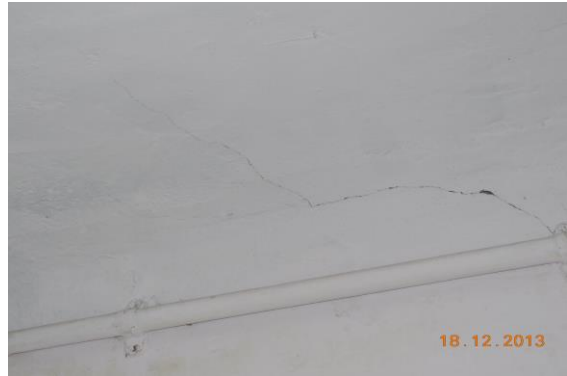
Photo 14

Inclined Crack on Wall No. 4 & Roof of Hall No. 2, First Floor
Approx. Width = 0.4mm, Approx. Length = 0.5m.
Distance from Wall No.1 = 0.5m, Height from Floor = 2.5m.

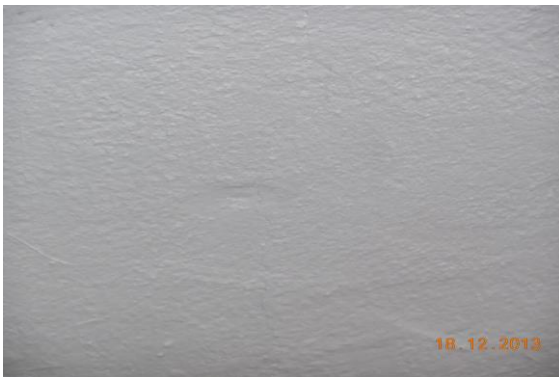
Photo 15

Horizontal Crack on Roof of Hall No. 2, First Floor
Approx. Width = 0.2mm, Approx. Length = 3m.
Distance from Wall No.3 = 2.6m, Height from Floor = 2.5m.

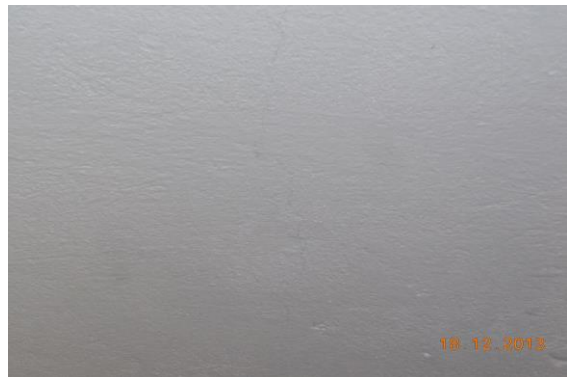
Photo 16

Horizontal Crack on Roof of Hall No. 2, First Floor
Approx. Width = 0.2mm, Approx. Length = 3m.
Distance from Wall No.3 = 3.8m, Height from Floor = 2.5m.

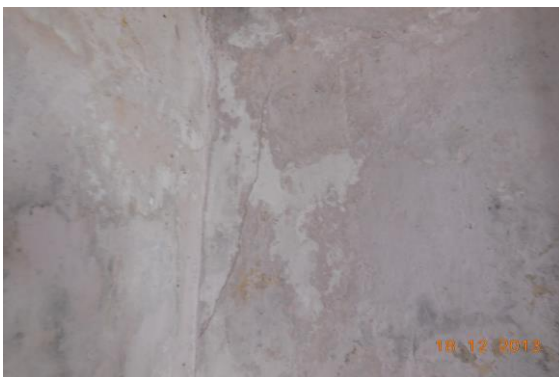
Photo 17

Inclined Crack on Wall No. 1 of Hall No. 2, First Floor
Approx. Width = 0.5mm, Approx. Length = 0.5m.
Distance from Wall No.3 = 0m, Height from Floor = 1.58m.

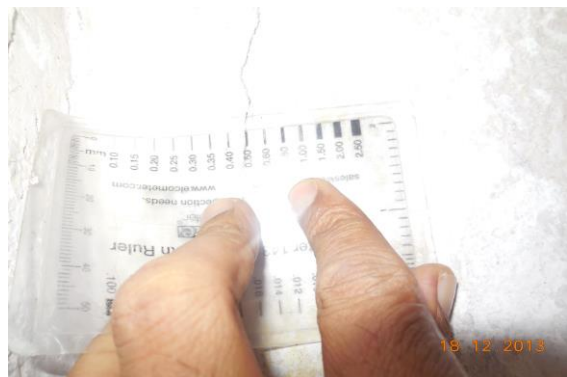
Photo 17A

Inclined Crack on Wall No. 1 of Hall No. 2, First Floor
Approx. Width = 0.5mm, Approx. Length = 0.5m.
Distance from Wall No.3 = 0m, Height from Floor = 1.58m.

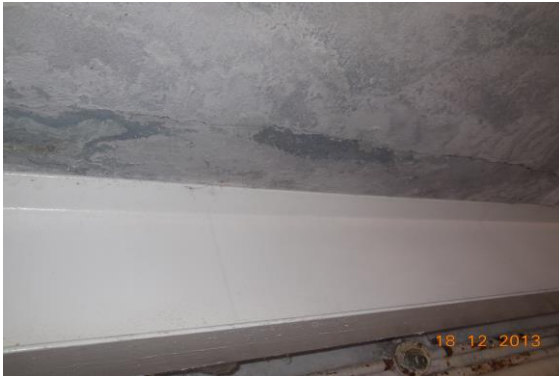
Photo 18

Horizontal Crack on Roof of Hall No. 2, First Floor
Approx. Width = 1mm, Approx. Length = 3m.
Distance from Wall No.1 & 3 = 0m, Height from Floor = 2.5m.

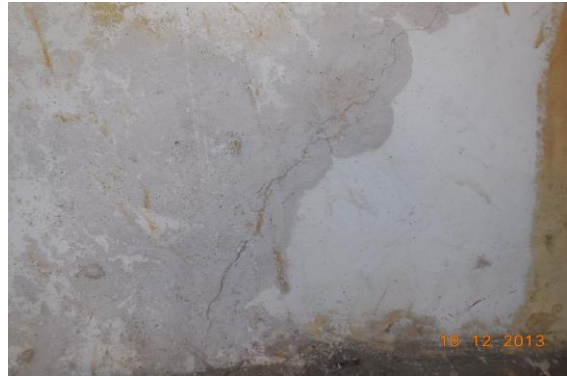
Photo 19

Inclined Crack on Wall No. 1 of Passage, First Floor
Approx. Width = 0.15mm, Approx. Length = 1m.
Distance from Wall No.3 = 5.5m, Height from Floor = 0.3m.

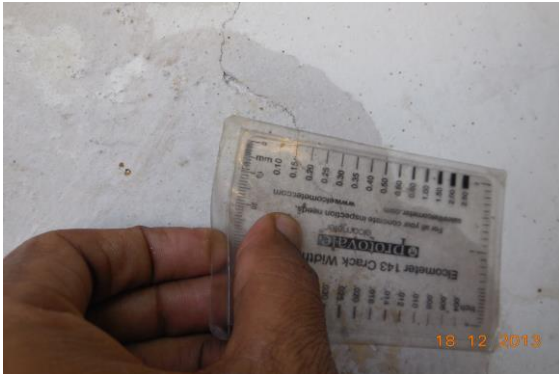
Photo 19A

Inclined Crack on Wall No. 1 of Passage, First Floor
Approx. Width = 0.15mm, Approx. Length = 1m.
Distance from Wall No.3 = 5.5m, Height from Floor = 0.3m.

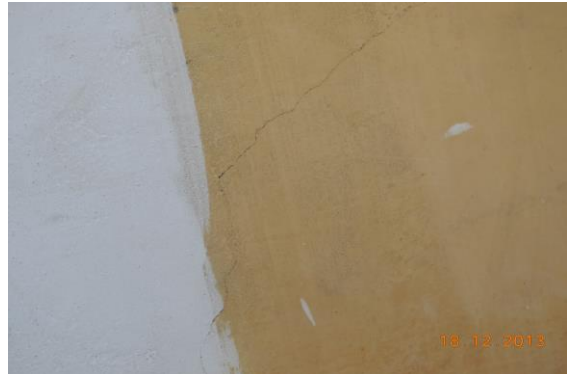
Photo 20

Inclined Crack on Wall No. 1 of Passage, First Floor
Approx. Width = 0.15mm, Approx. Length = 0.32m.
Distance from Wall No = 5.7m, Height from Floor = 1m.

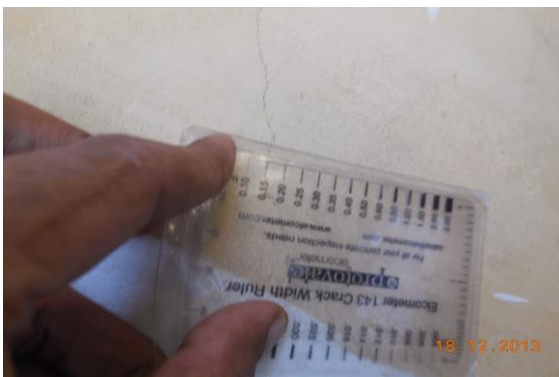
Photo 20A

Inclined Crack on Wall No. 1 of Passage, First Floor
Approx. Width = 0.15mm, Approx. Length = 0.32m.
Distance from Wall No = 5.7m, Height from Floor = 1m.

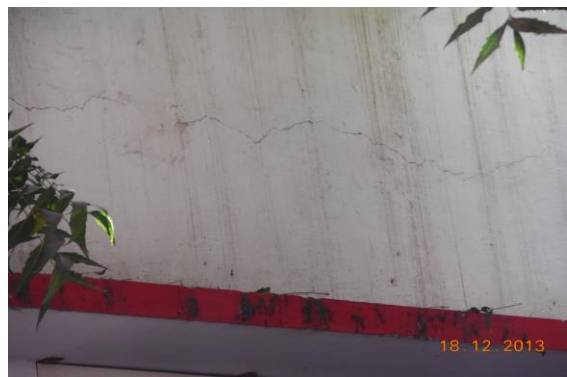
Photo 21

Inclined Crack on Outside Wall & 3 of Office Hall, Ground Floor Approx.
Width = 1mm, Approx. Length = 11m. Distance from Main Gate = 0m,
Height from Floor = 3.6m.

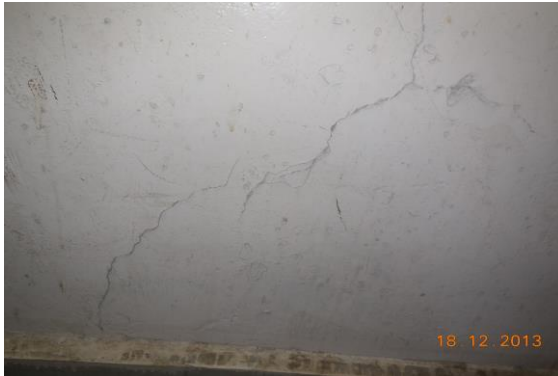
Photo 22

Inclined Crack on Wall No. 4 of Staircase Ground Floor To First Floor,
Ground Floor Approx. Width = 0.35mm, Approx. Length = 0.6m.
Distance from Wall No.1 = 1m, Height from Floor = 0.1m.

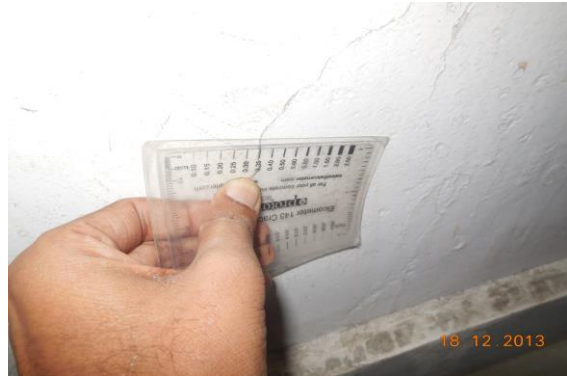
Photo 22A

Inclined Crack on Wall No. 4 of Staircase Ground Floor To First Floor,
Ground Floor Approx. Width = 0.35mm, Approx. Length = 0.6m.
Distance from Wall No.1 = 1m, Height from Floor = 0.1m.

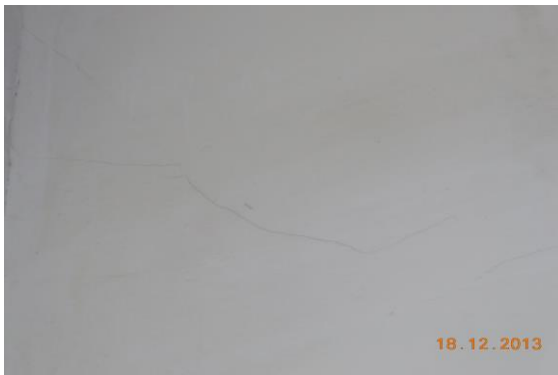
Photo 23

Plaster Crack on Lobby of Post Office of Ground Floor

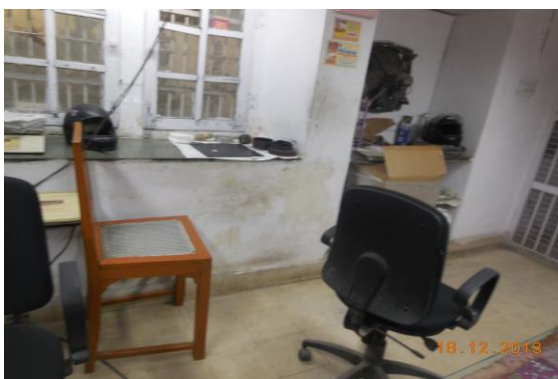
Photo 25

Peeling of Plaster on Wall No. 1 of Hall No. 1 of Ground Floor

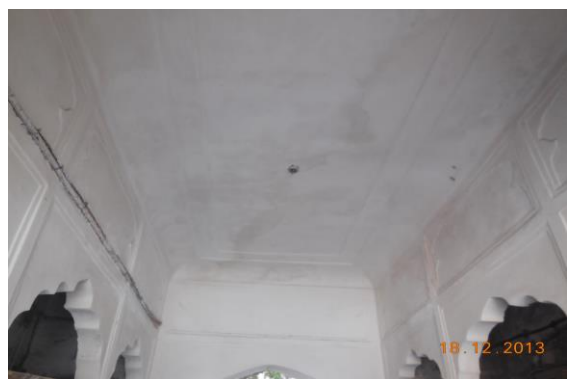
Photo 26

Dampness/Seepage on Wall No. 1, 2 & Roof of Post Office of Ground Floor

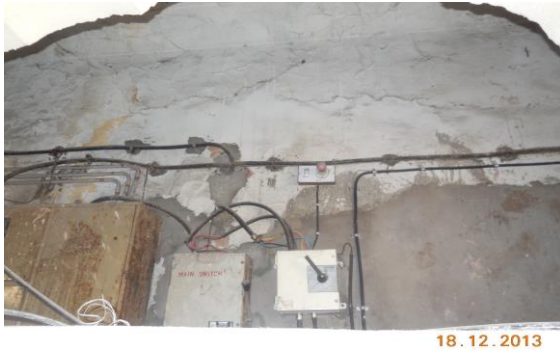
Photo 27

Peeling of Plaster on Wall No. 4 of Right Hand Side Varanda of Ground Floor

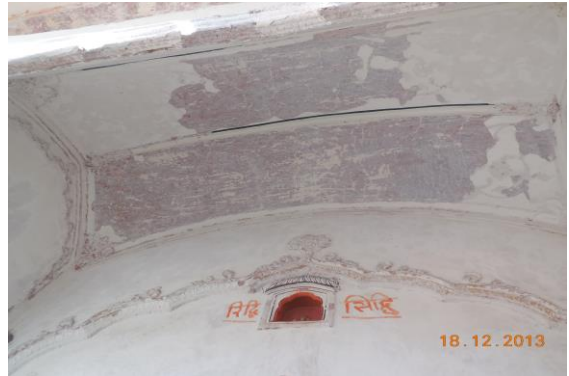
Photo 28

Peeling of Plaster on Roof of Right Hand Side Varanda of Ground Floor

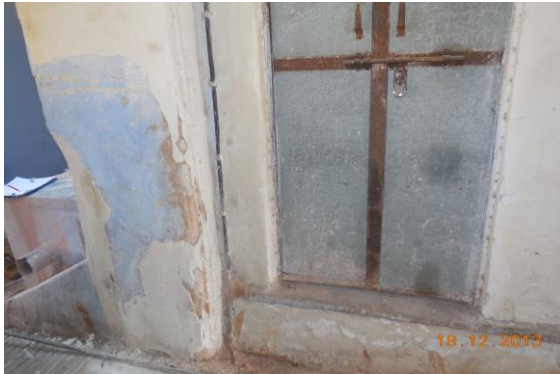
Photo 29

Peeling of Plaster on Wall No. 2 & Main gate of Right Hand Side Varanda of Ground Floor

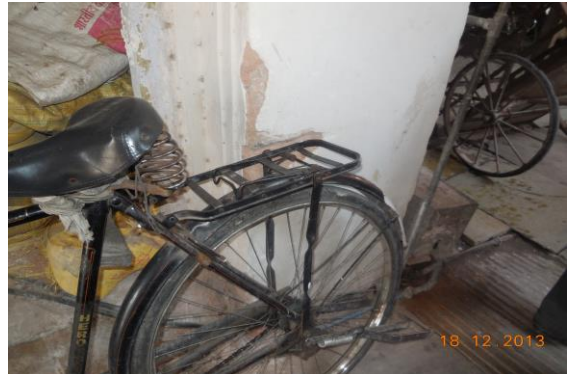
Photo 30

Peeling of Plaster on Wall No. 1 of Left Hand Side Varanda of Ground Floor

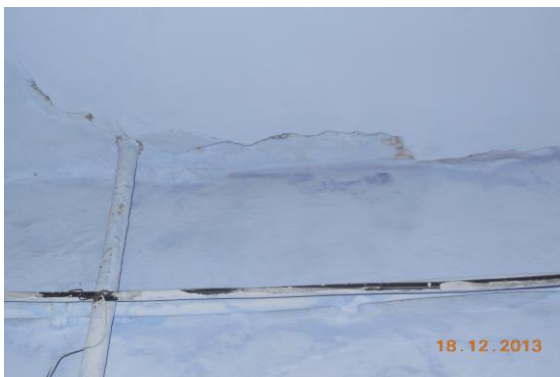
Photo 31

Peeling of Plaster on Roof of Temple (Right Hand Side) of Ground Floor

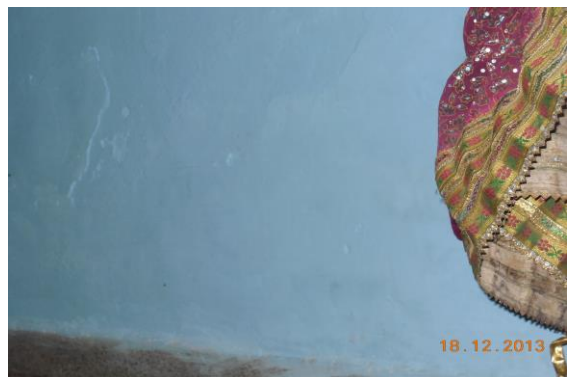
Photo 32

Peeling of Plaster on Wall No. 2 of Temple of Ground Floor

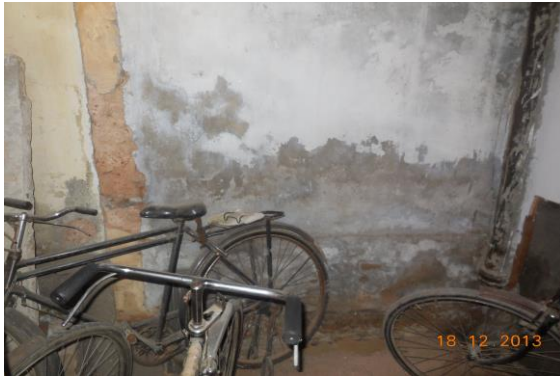
Photo 33

Peeling of Plaster on Wall No. 1 of Varanda No.3 of Ground Floor

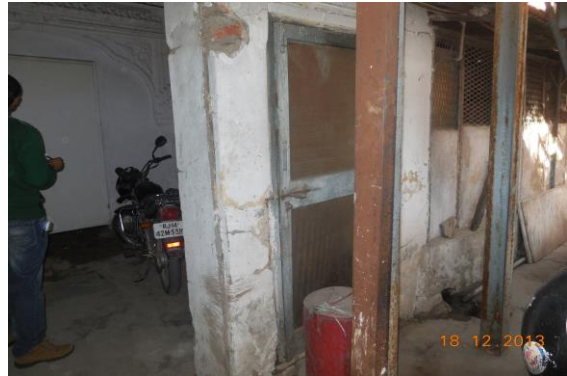
Photo 34

Damaged Portion on Outside Wall & 3 of Varanda No.3 of Ground Floor

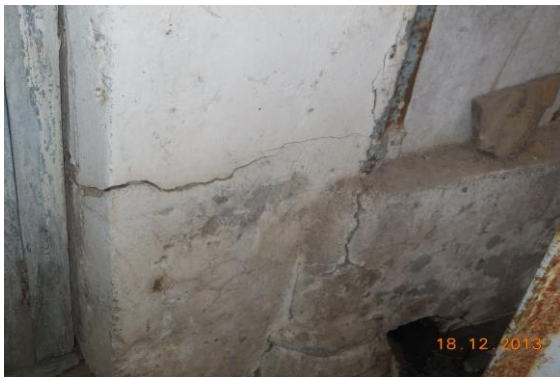
Photo 35

Damaged Portion on Outside Wall & 3 of Varanda No.3 of Ground Floor

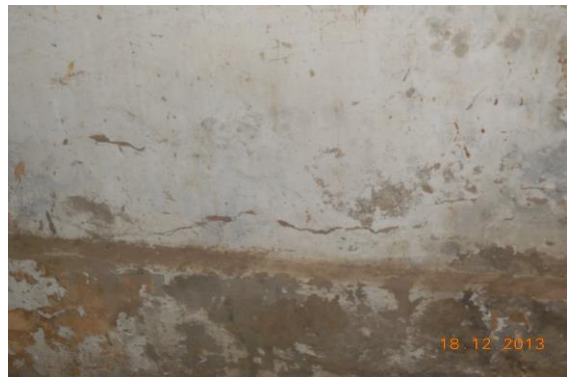
Photo 36

Dampness/Seepage on Wall No. 2 of Varanda No.3 of Ground Floor

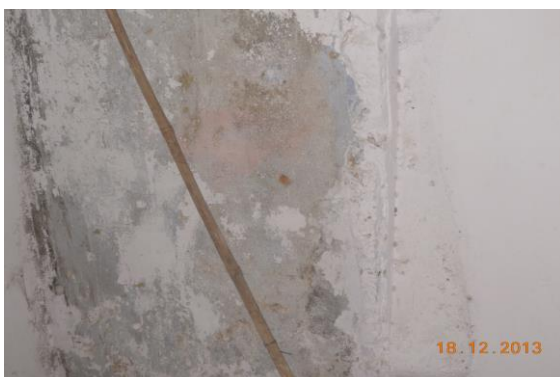
Photo 37

Dampness/Seepage on Wall No. 4 of Varanda No.3 of Ground Floor

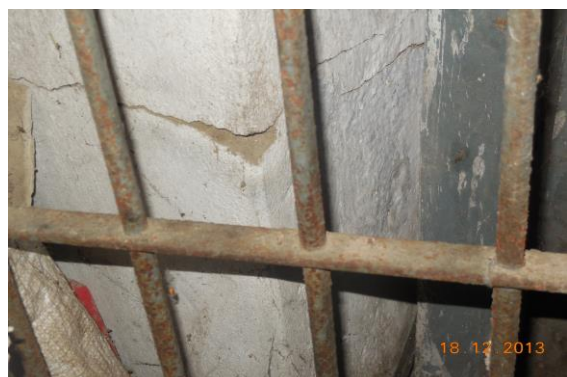
Photo 38

Peeling of Plaster on Inside Wall & 3 of Varanda No.3 of Ground Floor

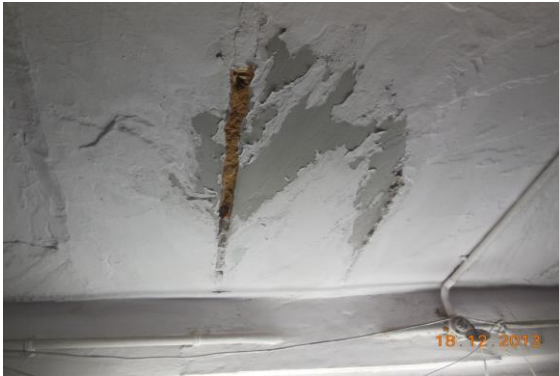
Photo 39
Peeling of Plaster on Roof of Hall No. 1 of First Floor

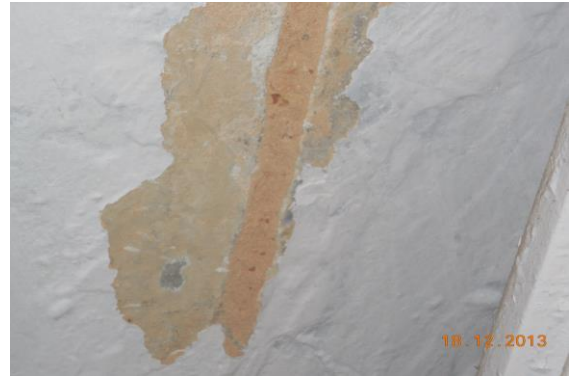
Photo 40
Peeling of Plaster on Roof of Hall No. 1 of First Floor

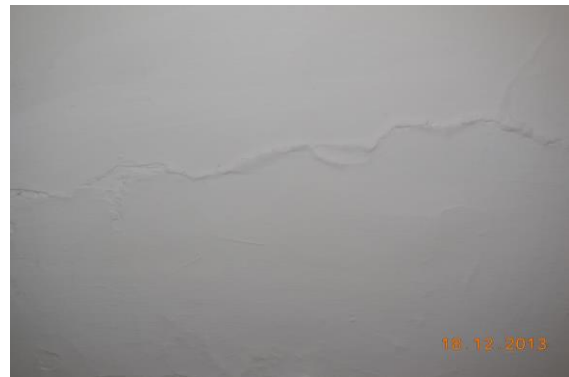
Photo 42
Plaster Crack on Roof of Passage of First Floor

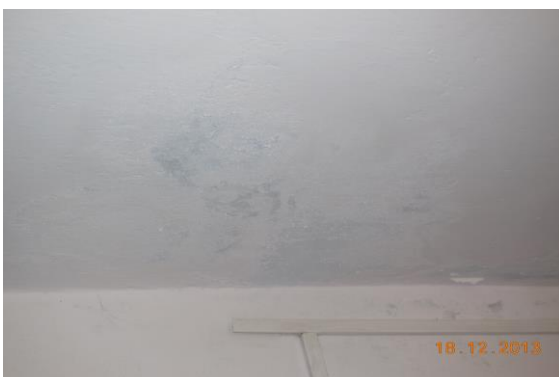
Photo 43
Dampness/Seepage on Roof of Room No. 1 of First Floor

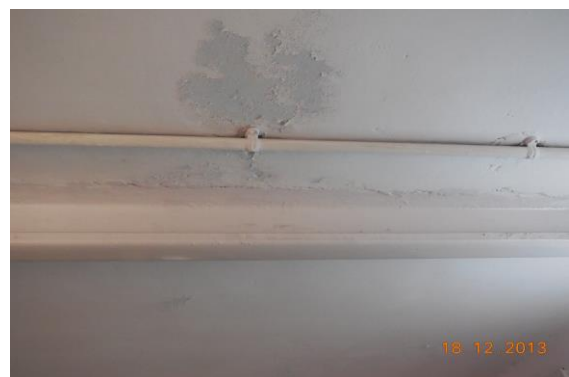
Photo 44
Dampness/Seepage on Roof of Room No. 1 of First Floor

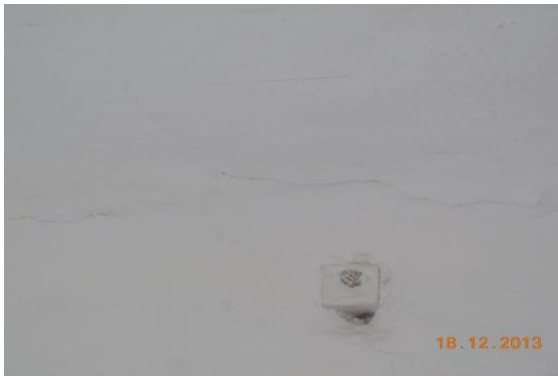
Photo 45
Plaster Crack on Wall No. 4 of Room No. 2 of First Floor

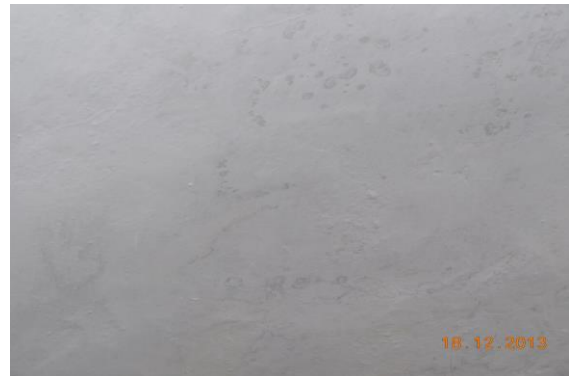
Photo 46
Dampness/Seepage on Roof of Room No. 3 of First Floor

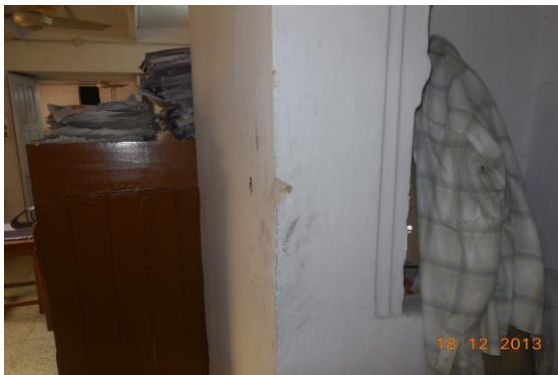
Photo 47
Peeling of Plaster on Wall No. 3 of Room No. 3 of First Floor

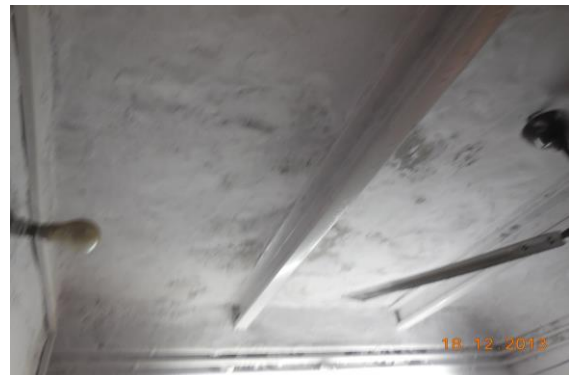
Photo 48
Dampness/Seepage on Roof of Registry Room of First Floor

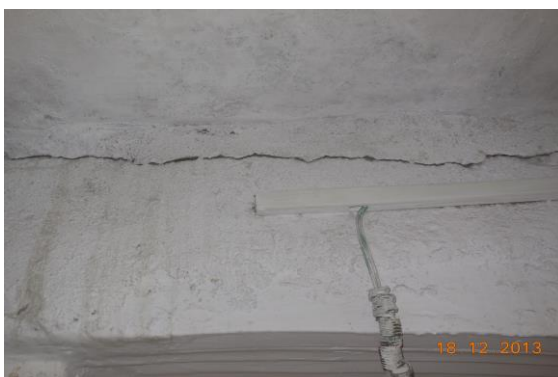
Photo 49
Peeling of Plaster on Wall No. 3 of Registry Room of First Floor

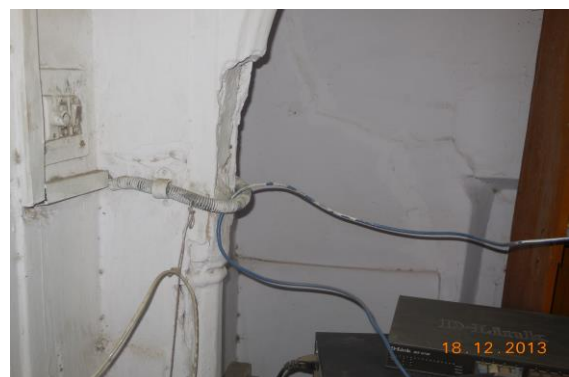
Photo 50
Peeling of Plaster on Wall No. 1 of Registry Room of First Floor

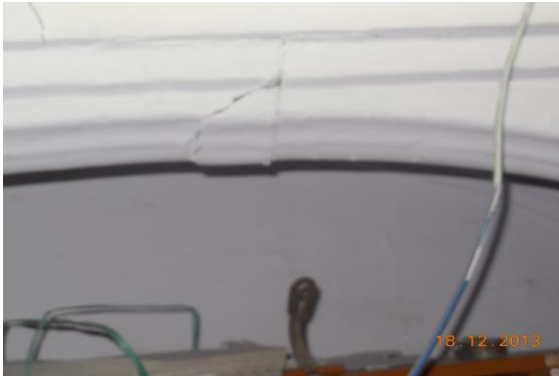
Photo 51
Damaged Portion on Wall No. 1 of Registry Room of First Floor

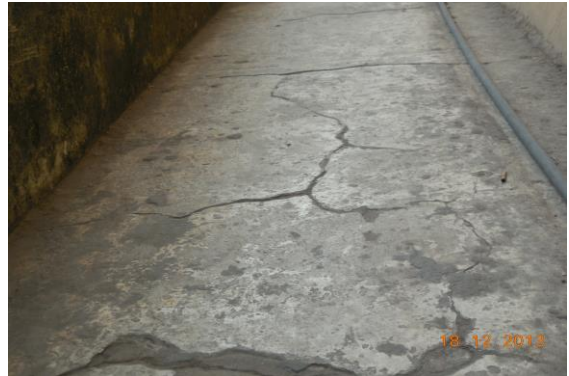
Photo 52
Plaster Crack on Floor of Passage of First Floor

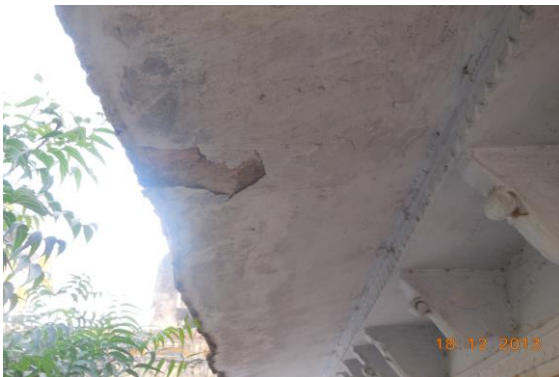
Photo 53
Damaged Portion on Roof Shade of Passage of First Floor

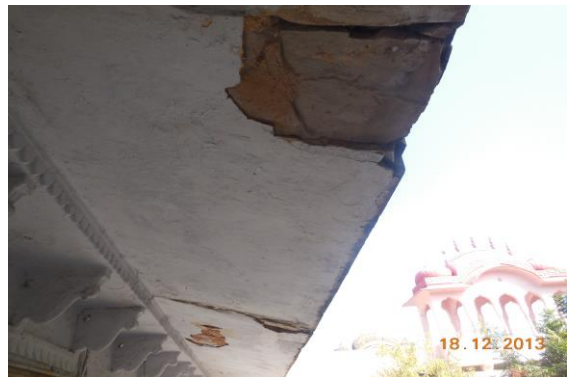
Photo 54
Damaged Portion on Roof Shade of Passage of First Floor

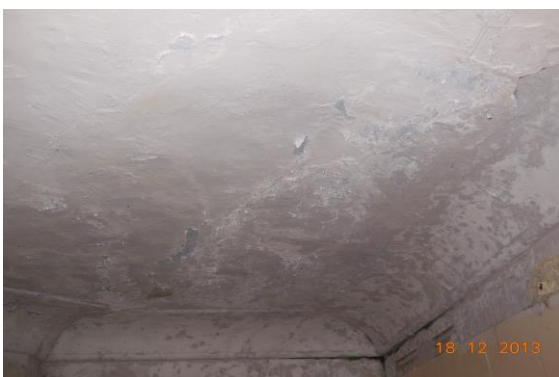
Photo 55
Dampness/Seepage on Roof of Toilet No. 1 of First Floor

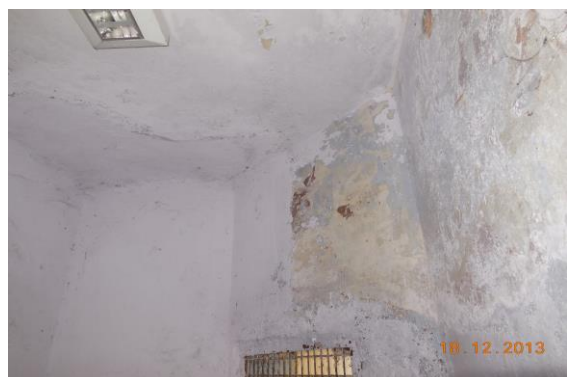
Photo 56
Dampness/Seepage on Wall No. 4, 2 & Roof of Toilet No. 1 of First Floor

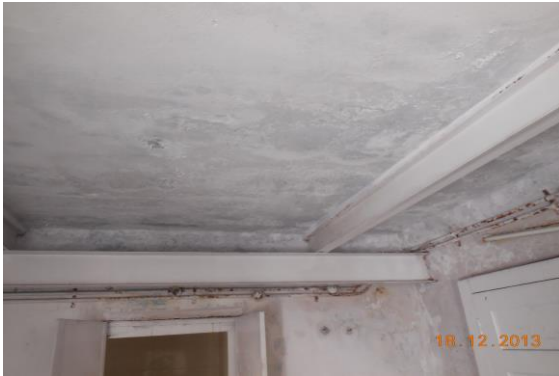
Photo 57
Dampness/Seepage on Roof of Hall No. 2 of First Floor

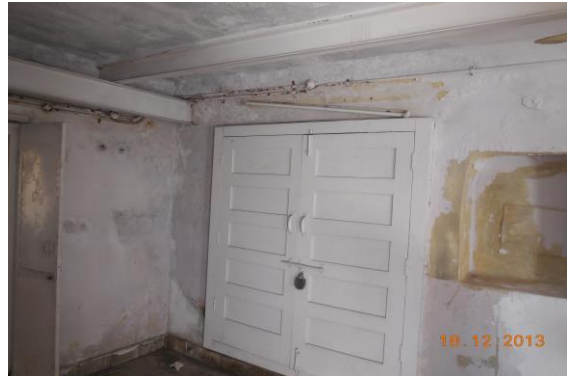
Photo 58
Dampness/Seepage on Wall No. 1 & 3 of Hall No. 2 of First Floor

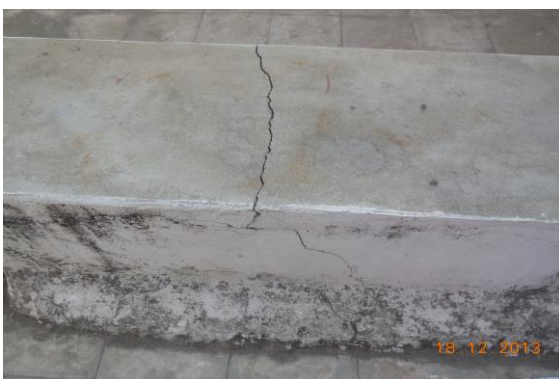
Photo 61
Damaged Portion on Parapet Wall of Post Office of First Floor

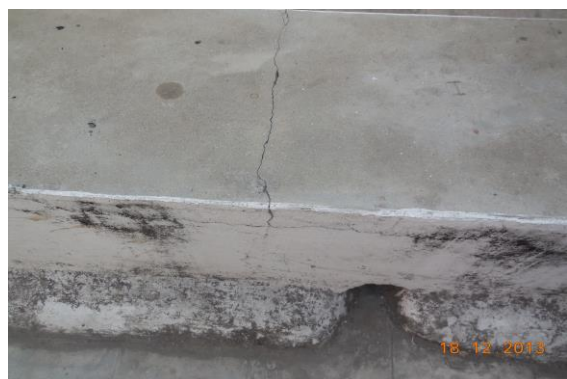
Photo 62
Damaged Portion on Parapet Wall of Post Office of First Floor

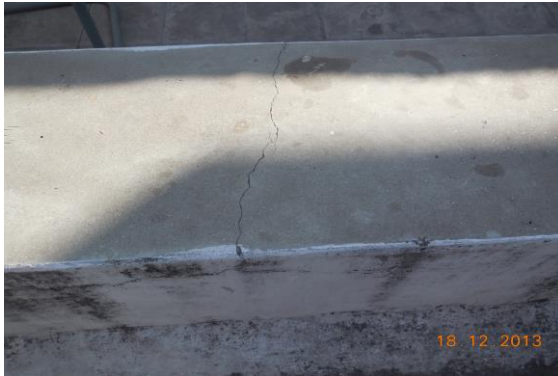
Photo 63
Damaged Portion on Parapet Wall of Post Office of First Floor

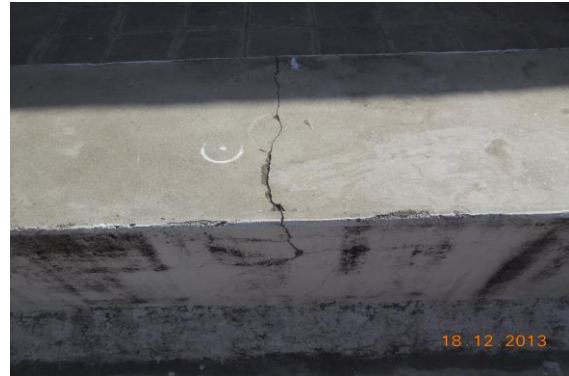
Photo 64
Damaged Portion on Parapet Wall of Post Office of First Floor

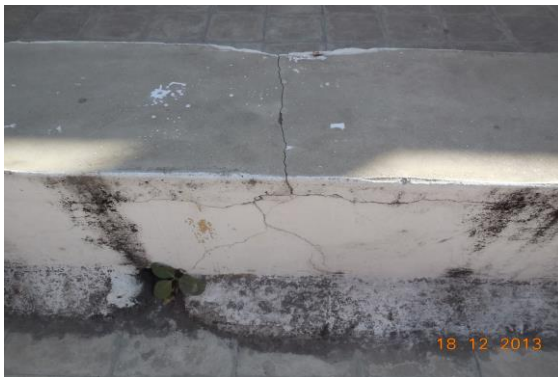
Photo 65
Damaged Portion on Parapet Wall of Post Office of First Floor

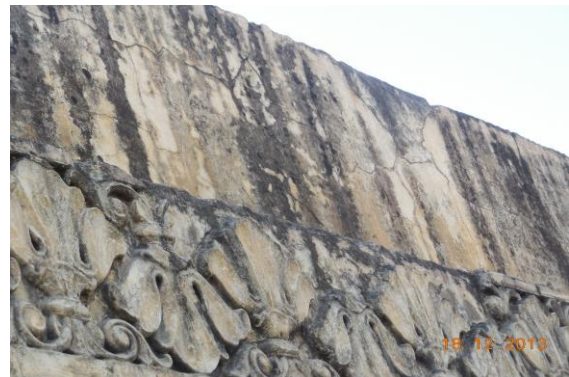
Photo 66
Plaster Crack on Parapet Wall of Post Office of Terrace

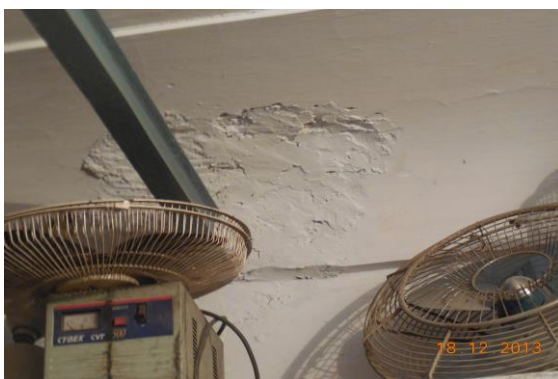
Photo 67
Peeling of Plaster on Roof of Room No. 2 of Ground Floor

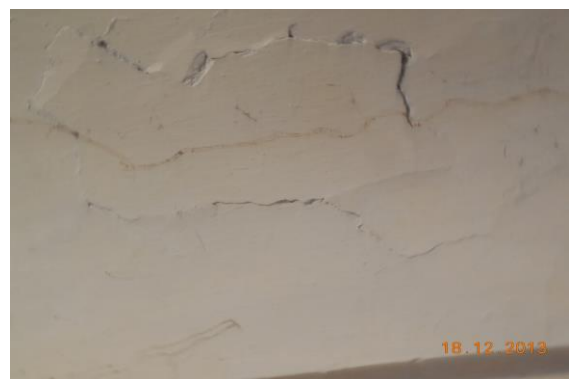
Photo 68
Peeling of Plaster on Roof of Room No. 2 of Ground Floor

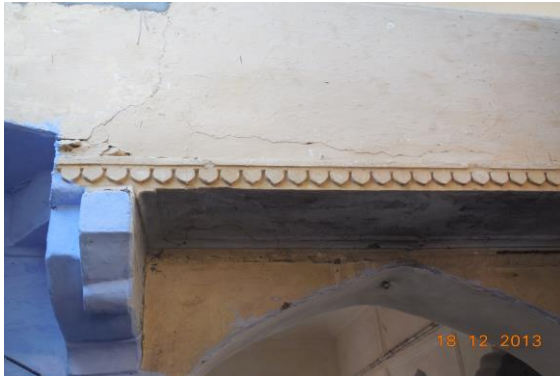
Photo 69
Plaster Crack on Inside Gate of Post Office of Ground Floor

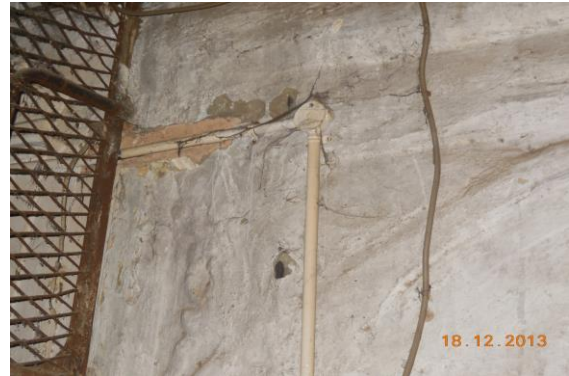
Photo 70
Peeling of Plaster on Wall No. 4 of Varanda No.1 of Ground Floor

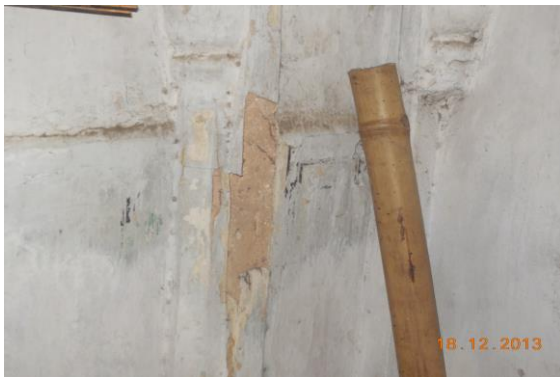
Photo 71
Peeling of Plaster on Wall No. 4 of Varanda No.1 of Ground Floor

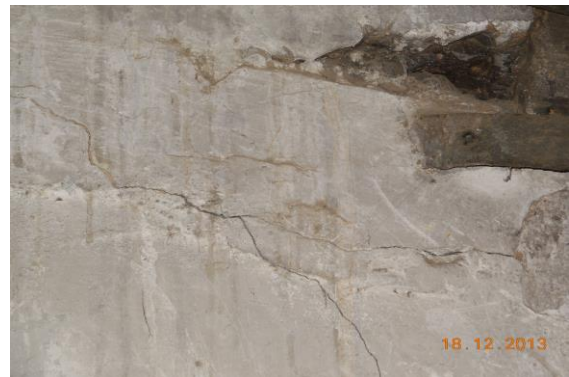
Photo 72
Damaged Portion on Wall No. 2 of Varanda No.1 of Ground Floor

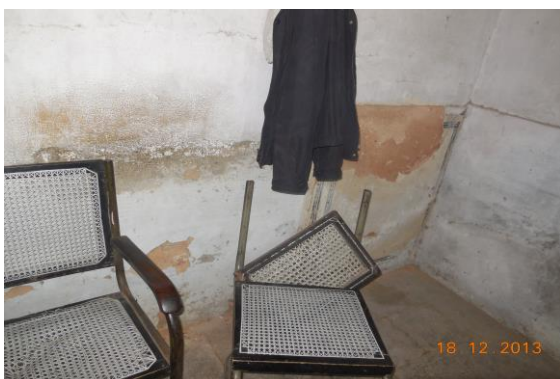
Photo 73
Damaged Portion on Wall No. 1 of Room No. 1 of Ground Floor

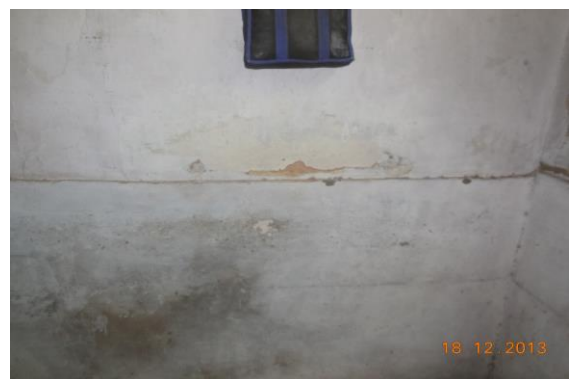
Photo 74
Peeling of Plaster on Wall No. 4 of Room No. 1 of Ground Floor

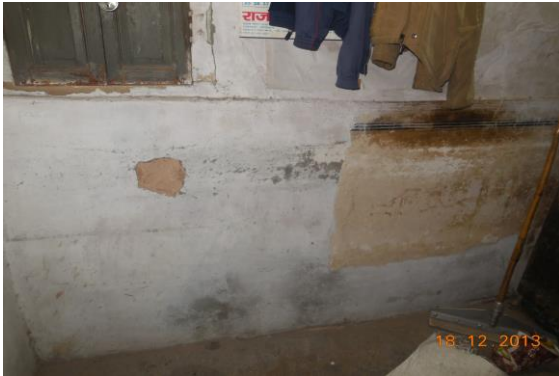
Photo 75

Peeling of Plaster on Wall No. 2 of Room No. 1 of Ground Floor

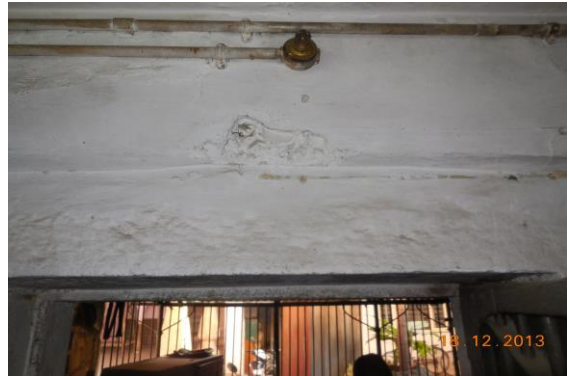
Photo 76

Peeling of Plaster on Wall No. 3 of Room No. 1 of Ground Floor

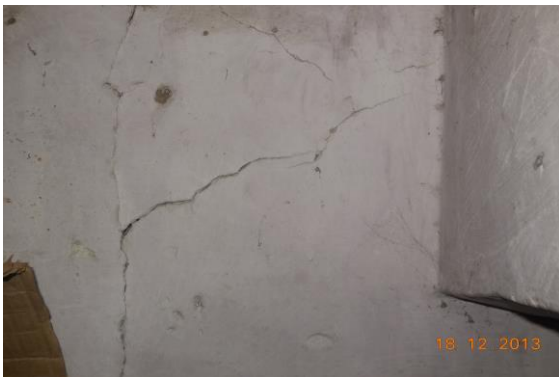
Photo 77

Plaster Crack on Wall No. 1 of Room No. 1 of Ground Floor

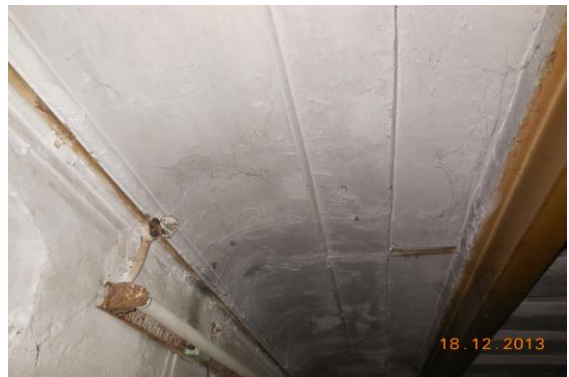
Photo 78

Dampness/Seepage on Roof of Room No. 2 of Ground Floor

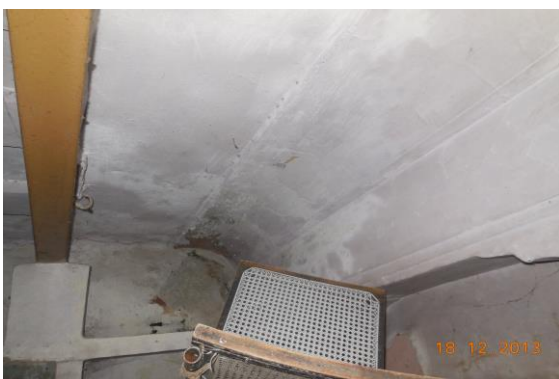
Photo 79

Dampness/Seepage on Roof of Room No. 2 of Ground Floor

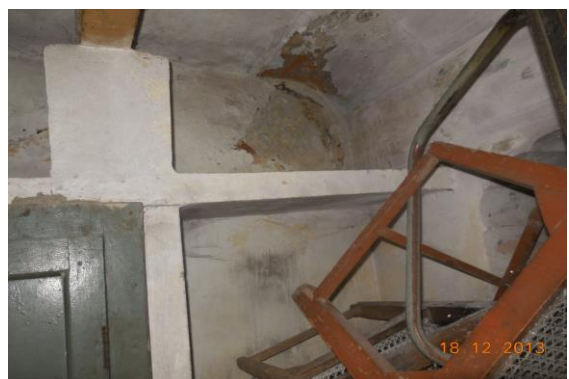
Photo 80

Dampness/Seepage on Wall No. 1 & Roof of Room No. 2 of Ground Floor

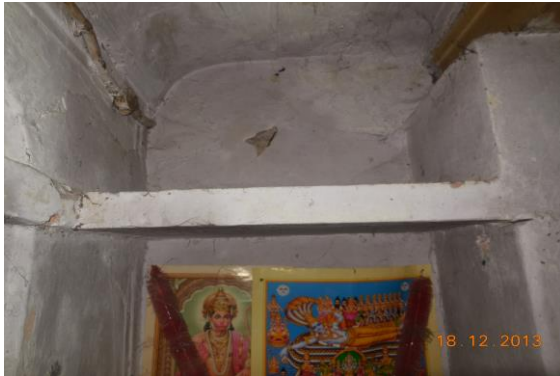
Photo 81

Dampness/Seepage on Wall No. 1 & Roof of Room No. 2 of Ground Floor

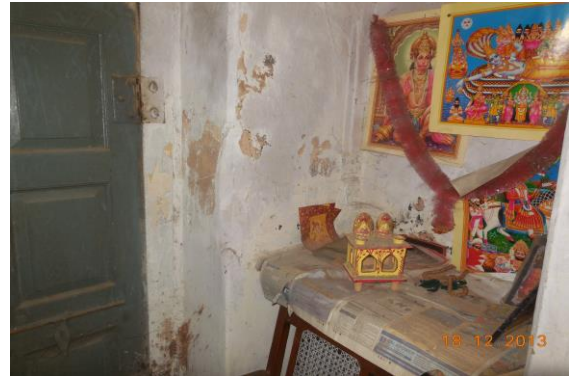
Photo 82

Peeling of Plaster on Wall No. 3 of Room No. 2 of Ground Floor

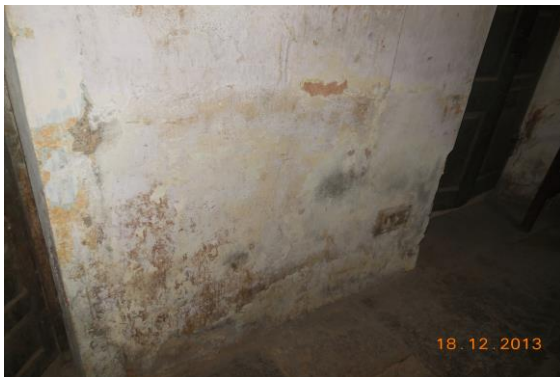
Photo 83

Peeling of Plaster on Wall No. 3 of Room No. 2 of Ground Floor

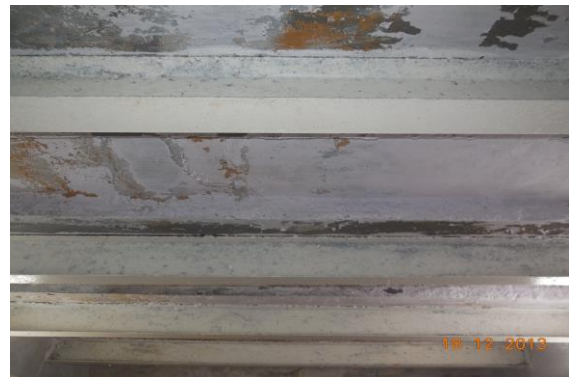
Photo 84

Dampness/Seepage on Roof of Toilet No. 1 of Ground Floor

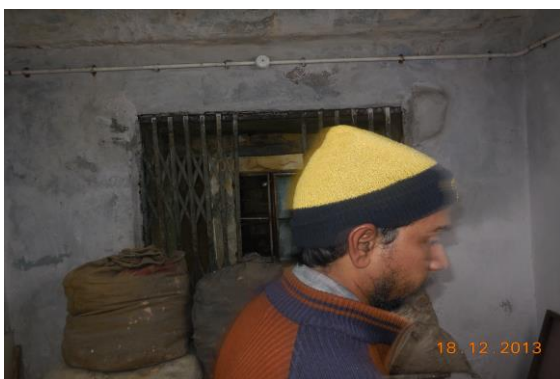
Photo 85

Dampness/Seepage on Wall No. 4 of Toilet No. 1 of Ground Floor

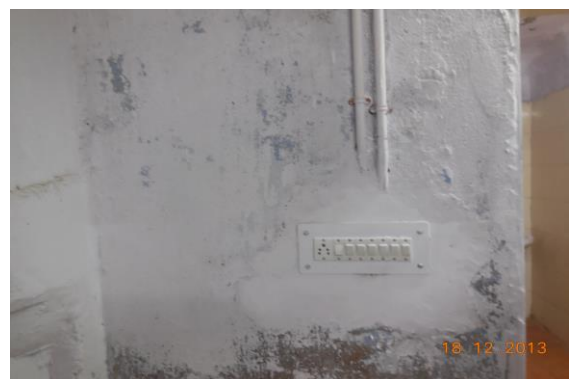
Photo 86

Dampness/Seepage on Wall No. 1 of Toilet No. 1 of Ground Floor

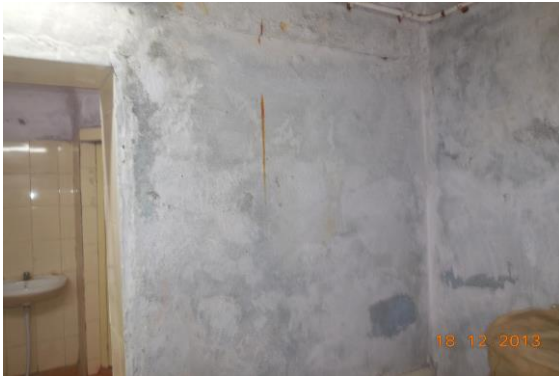
Photo 87

Dampness/Seepage on Wall No. 1 of Toilet No. 1 of Ground Floor

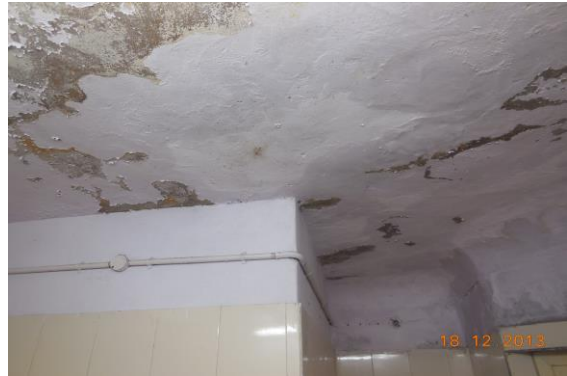
Photo 88

Dampness/Seepage on Roof of Toilet No. 1 of Ground Floor

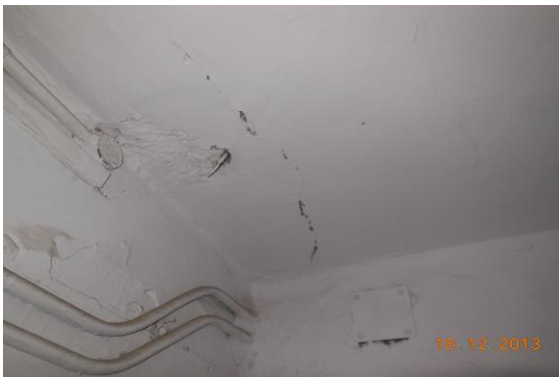
Photo 89

Peeling of Plaster on Roof of Staircase Ground Floor To First Floor of Ground Floor

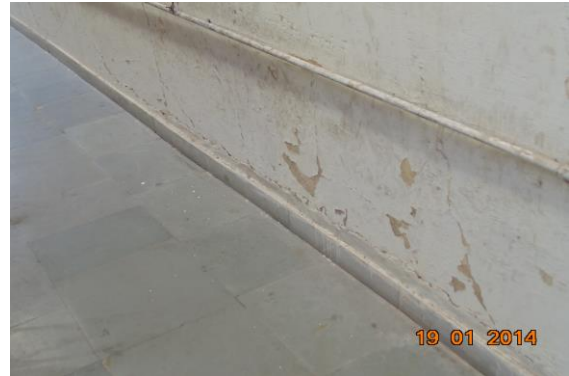
Photo 14
Horizontal Crack on Wall No. 1 of Passage 3, Police H.Q. First Floor, Part B, Approx. Width = 5mm, Approx. Length = 3m. Distance from Wall 4 = 0m, Height from Floor = 0.12m.

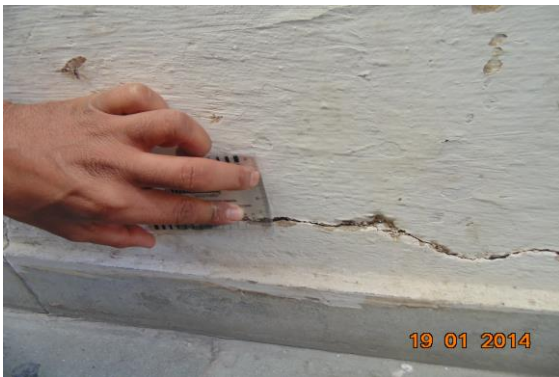
Photo 14A
Horizontal Crack on Wall No. 1 of Passage 3, Police H.Q. First Floor, Part B, Approx. Width = 5mm, Approx. Length = 3m. Distance from Wall 4 = 0m, Height from Floor = 0.12m.

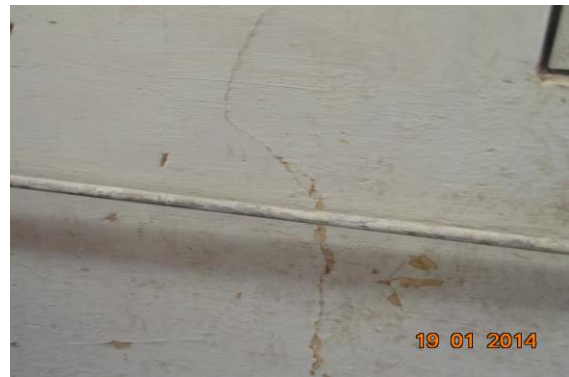
Photo 15
Inclined Crack on Wall No. 1 of , Police H.Q. First Floor, Part B, Approx. Width = 0.35mm, Approx. Length = 1m. Distance from Wall 4 = 3.2m, Height from Floor = 0.12m.

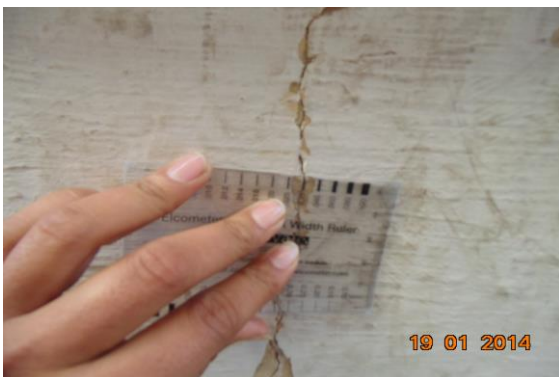
Photo 15A
Inclined Crack on Wall No. 1 of , Police H.Q. First Floor, Part B, Approx. Width = 0.35mm, Approx. Length = 1m. Distance from Wall 4 = 3.2m, Height from Floor = 0.12m.

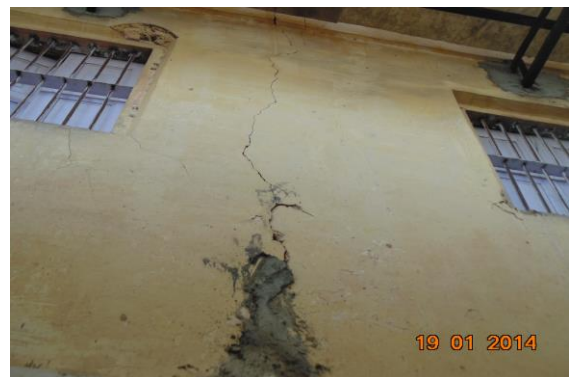
Photo 16
Inclined Crack on Wall No. 1 of , Police H.Q. First Floor, Part B, Approx. Width = 5mm, Approx. Length = 7m. Distance from Wall 4 = 3.2m, Height from Floor = 0m.

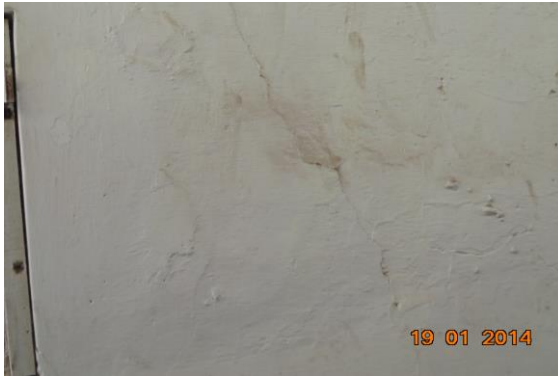
Photo 17

Inclined Crack on Wall No. 1 of , Police H.Q.First Floor,Part B,Approx.
Width = 5mm, Approx. Length = 7m.
Distance from Wall 4 = 3.2m, Height from Floor = 0m.

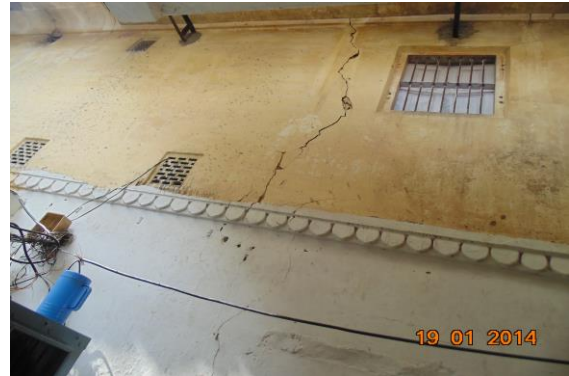
Photo 18

Inclined Crack on Wall No. 1 of , Police H.Q.First Floor,Part B,Approx.
Width = 10mm, Approx. Length = 6m.
Distance from Wall 4 = 1.4m, Height from Floor = 0m.

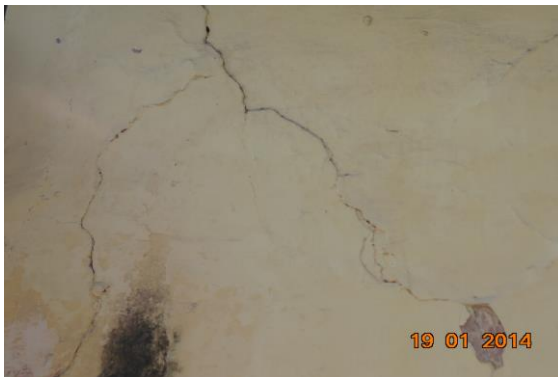
Photo 19

Inclined Crack on Outer Wall of External Façade Front Gate, First Floor
, Police H.Q.,Approx. Width = 5mm, Approx. Length = 2m.Distance
Main Gate Wall 3 = 30m, Height Floor = 2.1m.

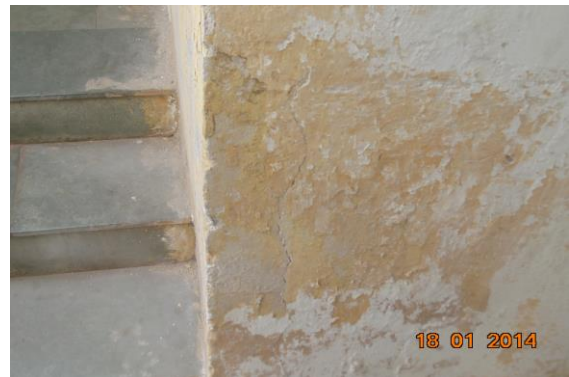
Photo 20

Vertical Crack on Wall No. 1 of Passage 2, Police H.Q.Ground Floor,
Part B,Approx. Width = 0.6mm, Approx. Length = 2.1m.Distance from
Wall 4 = 1.5m, Height from Floor = 0m.

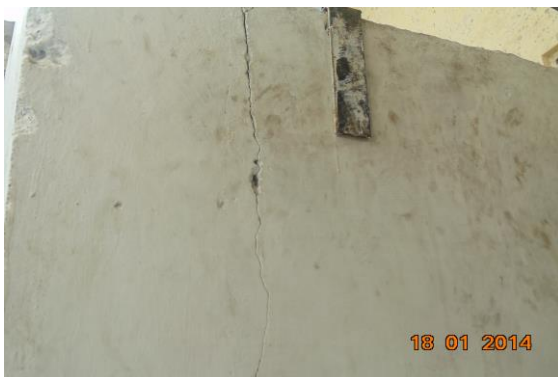
Photo 21

Vertical Crack on Wall No. 1 of Passage 2, Police H.Q.Ground Floor,
Part B,Approx. Width = 0.6mm, Approx. Length = 2.1m.Distance from
Wall 4 = 1.5m, Height from Floor = 0m.

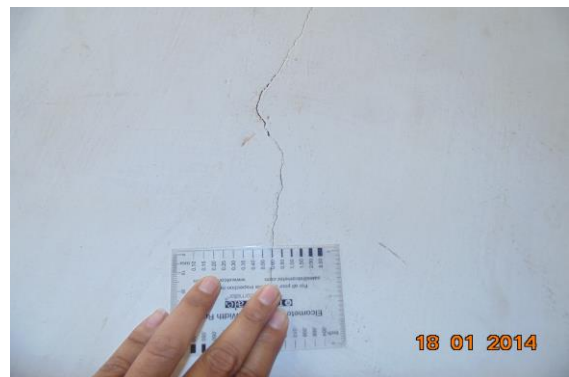
Photo 21A

Vertical Crack on Wall No. 1 of Passage 2, Police H.Q.Ground Floor,
Part B,Approx. Width = 0.6mm, Approx. Length = 2.1m.Distance from
Wall 4 = 1.5m, Height from Floor = 0m.

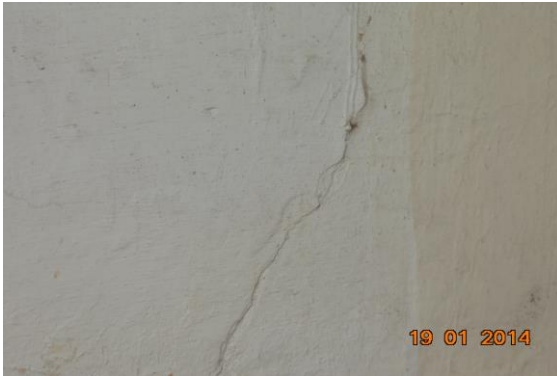
Photo 22

Vertical Crack on Wall No. 1 of Varanda 2, Police H.Q. Ground Floor, Part C, Approx. Width = 0.5mm, Approx. Length = 1m. Distance from Wall 4 = 2.2m, Height from Floor = 0.3m.

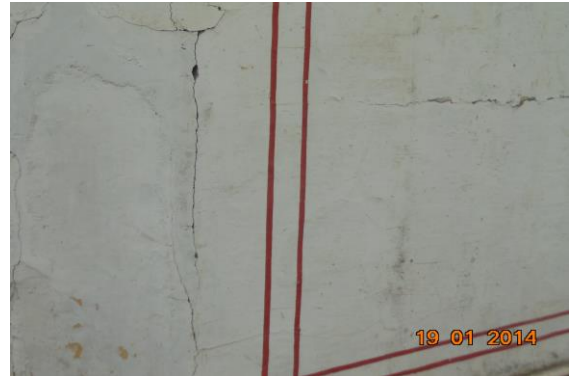
Photo 23

Vertical Crack on Wall No. 1 of Gate 2, Police H.Q. Ground Floor, Part C, Approx. Width = 1mm, Approx. Length = 1.8m. Distance from Wall 4 of Varanda 1 = 3.3m, Height from Floor = 0m.

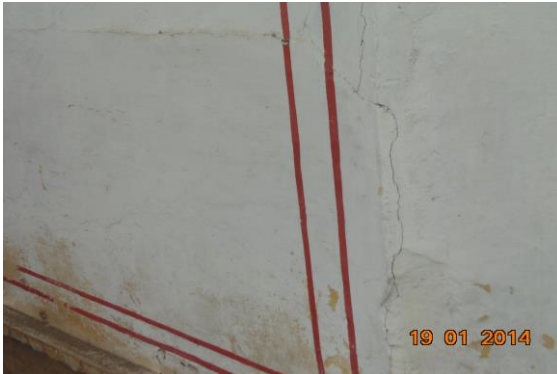
Photo 24

Inclined Crack on Wall No. 1 of Gate 2, Police H.Q. Ground Floor, Part C, Approx. Width = 0.4mm, Approx. Length = 1m. Distance from Wall 4 of Varanda 1 = 3m, Height from Floor = 0.5m.

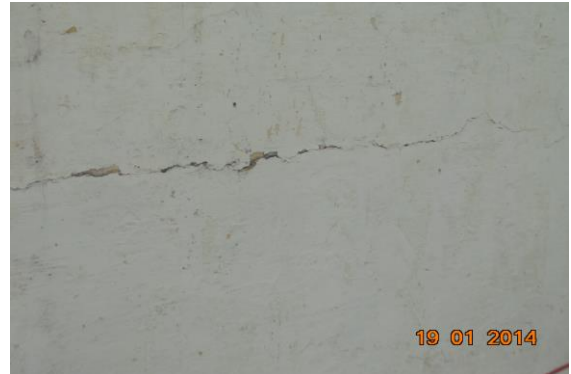
Photo 25

Horizontal Crack on Wall No. 1 of Gate 2, Police H.Q. Ground Floor, Part C, Approx. Width = 4mm, Approx. Length = 2m. Distance from Wall 3 of Varanda 1 = 3.3m, Height from Floor = 1.2m.

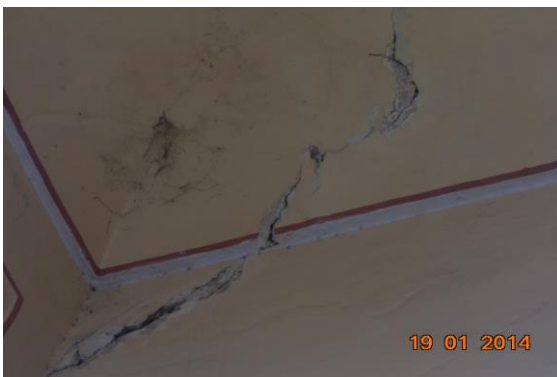
Photo 26

Inclined Crack on Wall No. 3 & Roof of Face 3 of Gate, Police H.Q. Ground Floor, Part C, Approx. Width = 5mm, Approx. Length = 3m. Distance Wall 3 & Roof = Wall 3 & Roof, Height Floor = 6m.

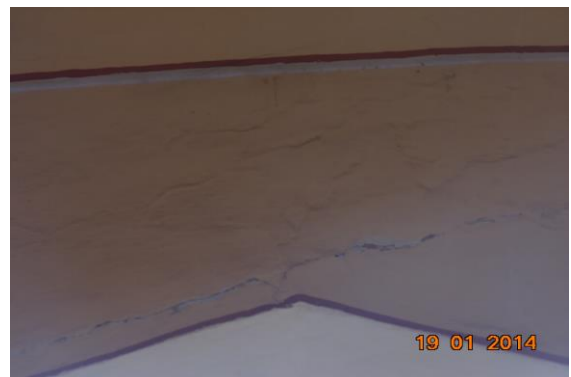
Photo 27

Horizontal Crack on Wall No. 3 of Gate, Police H.Q. Ground Floor, Part C, Approx. Width = 3mm, Approx. Length = 2.5m. Distance from Wall 4 & Wall 2 = 0m, Height from Floor = 5.3m.

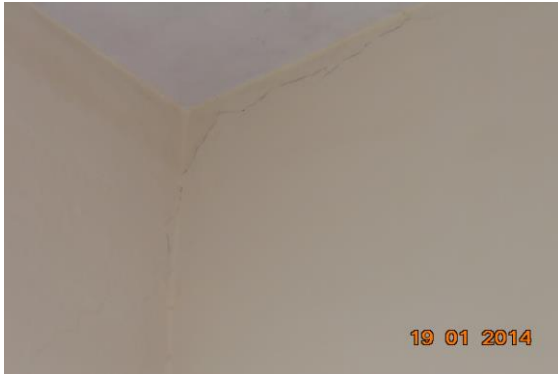
Photo 30

Inclined Crack on Wall No. 4 of Room No. 392, Police H.Q. First Floor, Part D, Approx. Width = 0.6mm, Approx. Length = 1m. Distance from Wall 1 = 0m, Height from Floor = 3m.
