Pre Building Condition Survey Report

Name and Address of Structure :	Choti Chopar to Badi Chopar (UP Line)
---------------------------------	---------------------------------------

Name of the Project	Contract JMRC-UG1B “Design and Construction of Tunnel between Chandpole and Badi Chouper and reverse line by Shield TBM, Underground Metro Stations at Choti Chouper and Badi Chouper by Cut and Cover Methods on East West Corridor of Jaipur Metro Rail Corporation Limited .”	
Owner :

Shoping Complex - Shop No. 169-188
Tripolia Bazar
Jaipur
Unique ID: CC BC UP 0001

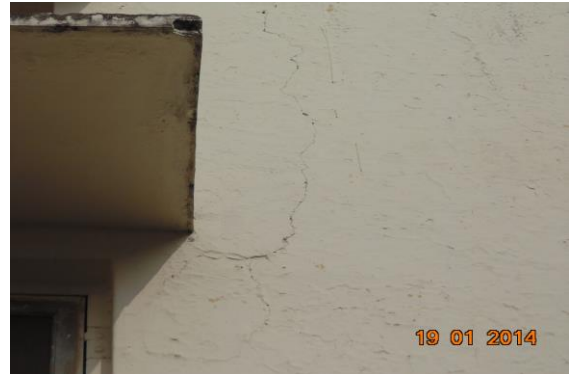
Photo 31

Inclined Crack on Wall No. 2 of Towards Gate, Police H.Q. First Floor, Part B, Approx. Width = 3mm, Approx. Length = 3m. Distance from Wall 3 = 11.3m, Height from Floor = 5m.

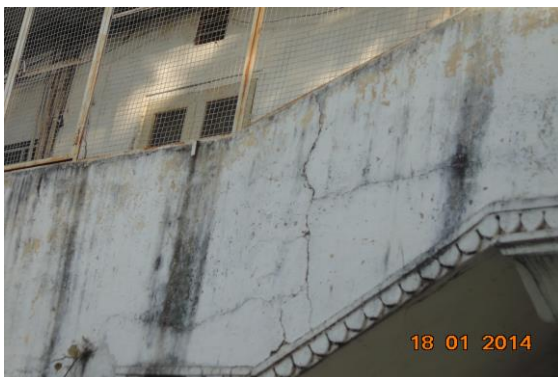
Photo 32

Inclined Crack on Wall No. 2 of Balcony 2, Police H.Q. Ground Floor, Part A, Approx. Width = 3mm, Approx. Length = 1.5m. Distance from Wall 3 = 3m, Height from Floor = 3m.

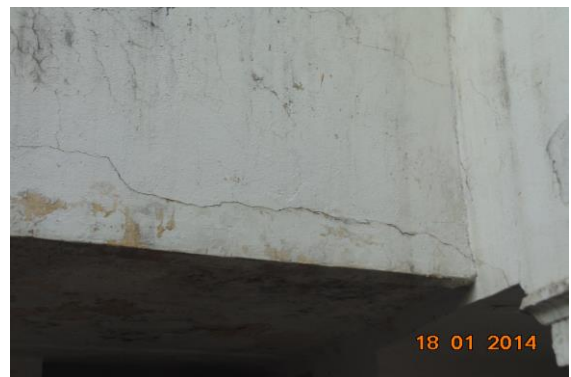
Photo 33

Inclined Crack on Wall No. 1 of Balcony 3, Police H.Q. Ground Floor, Part A, Approx. Width = 1mm, Approx. Length = 1.5m. Distance from Wall 1 of Balcony 2 = 0m, Height from Floor = 3m.

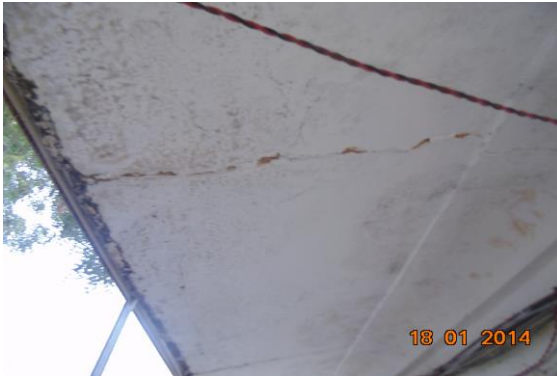
Photo 34

Inclined Crack on Roof of Balcony 1, Police H.Q. First Floor, Part A, Approx. Width = 1mm, Approx. Length = 1m.
Distance from Wall 2 of Balcony 2 = 0.3m, Height from Floor = 2m.

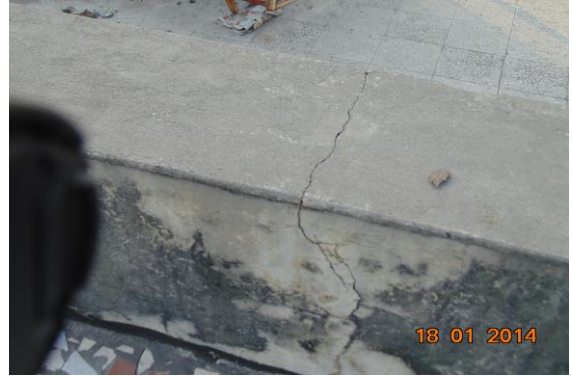
Photo 35

Inclined Crack on Wall No. 2 of Parapet Wall, Police H.Q. Terrace, Part A, Approx. Width = 0.8mm, Approx. Length = 1.5m.
Distance from Wall 3 = 10m, Height from Floor = 0m.

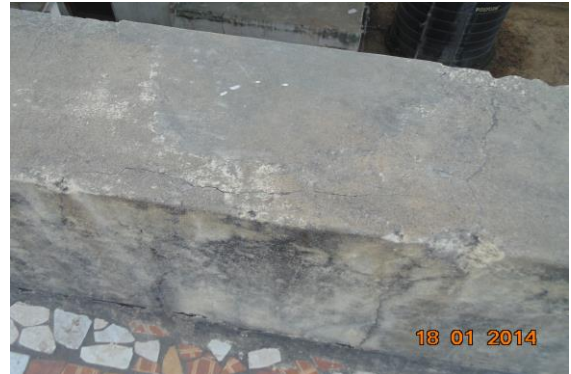
Photo 35A

Inclined Crack on Wall No. 2 of Parapet Wall, Police H.Q. Terrace, Part A, Approx. Width = 0.8mm, Approx. Length = 1.5m.
Distance from Wall 3 = 10m, Height from Floor = 0m.

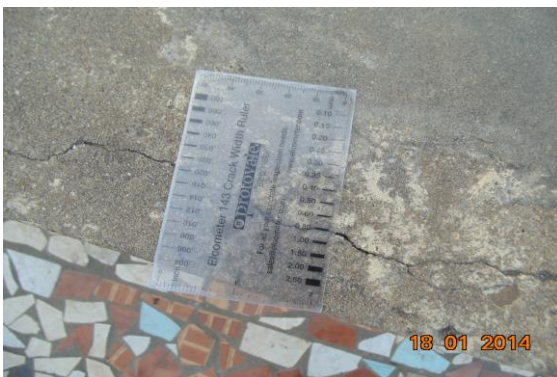
Photo 36

Inclined Crack on Top of Parapet Wall 1, Police H.Q. Terrace, Part A, Approx. Width = 0.8mm, Approx. Length = 0.4m. Distance from Wall 3 = 11m, Height from Floor = 0.35m.

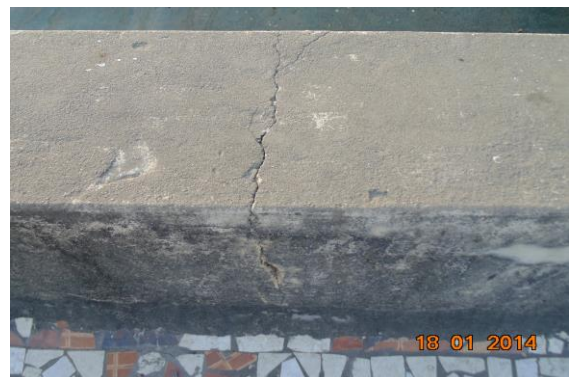
Photo 36A

Inclined Crack on Top of Parapet Wall 1, Police H.Q. Terrace, Part A, Approx. Width = 0.8mm, Approx. Length = 0.4m. Distance from Wall 3 = 11m, Height from Floor = 0.35m.

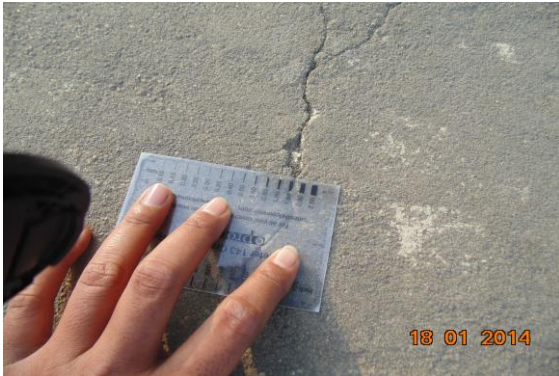
Photo 37

Inclined Crack on Top of Parapet Wall 1, Police H.Q. Terrace, Part A, Approx. Width = 1.5mm, Approx. Length = 1.5m. Distance from Wall 3 = 13m, Height from Floor = 0m.

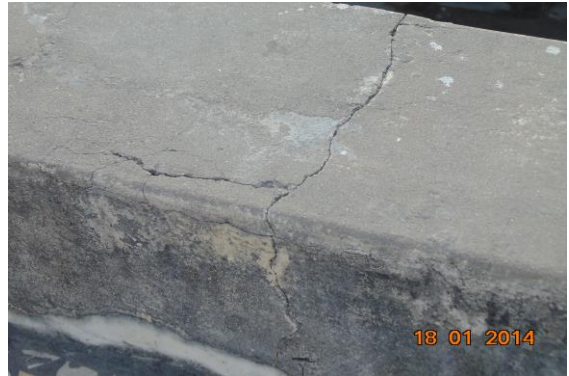
Photo 37A

Inclined Crack on Top of Parapet Wall 1, Police H.Q.Terrace, Part A
Approx. Width = 1.5mm, Approx. Length = 1.5m.
Distance from Wall 3 = 13m, Height from Floor = 0m.

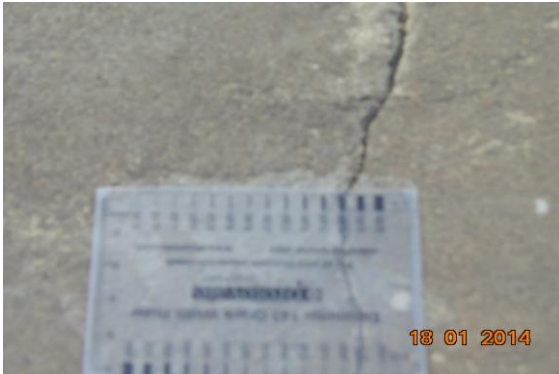
Photo 38

Inclined Crack on Top of Parapet Wall 1, Police H.Q.Terrace, Part A, Approx. Width = 1.5mm, Approx. Length = 1.5m. Distance from Wall 3 = 40m, Height from Floor = 0m.

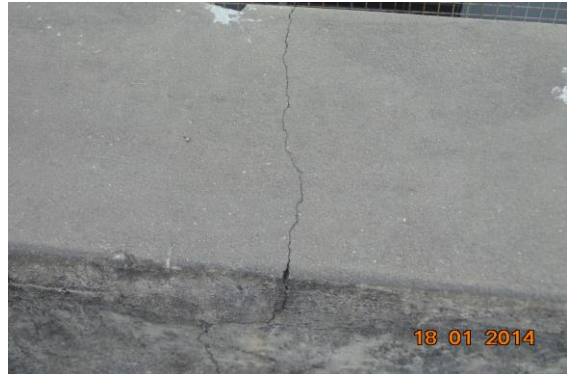
Photo 38A

Inclined Crack on Top of Parapet Wall 1, Police H.Q.Terrace, Part A, Approx. Width = 1.5mm, Approx. Length = 1.5m.
Distance from Wall 3 = 40m, Height from Floor = 0m.

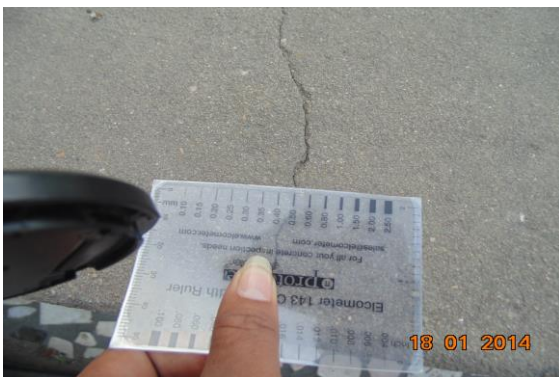
Photo 39

Inclined Crack on Top of Parapet Wall 1, Police H.Q.Terrace, Part A, Approx. Width = 0.5mm, Approx. Length = 1.5m.
Distance from Wall 4 = 3m, Height from Floor = 0m.

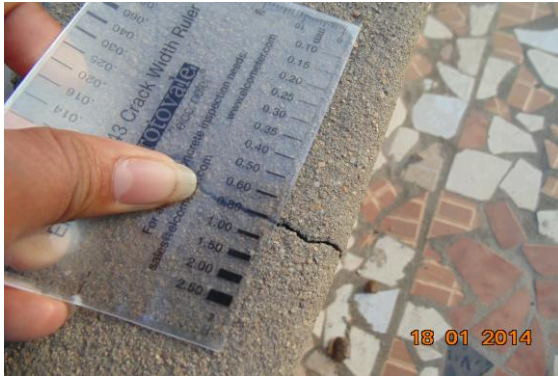
Photo 40

Inclined Crack on Wall No. 1 of Parapet Wall, Police H.Q.Terrace, Part A, Approx. Width = 0.8mm, Approx. Length = 1m.
Distance from Wall 4 = 22m, Height from Floor = 0m.

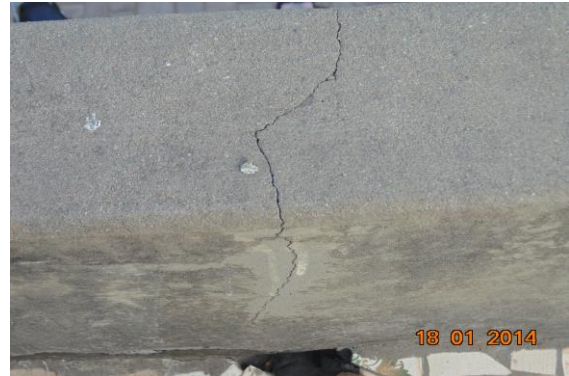
Photo 40A

Inclined Crack on Wall No. 1 of Parapet Wall , Police H.Q.Terrace, Part A, Approx. Width = 0.8mm, Approx. Length = 1m.
Distance from Wall 4 = 22m, Height from Floor = 0m.

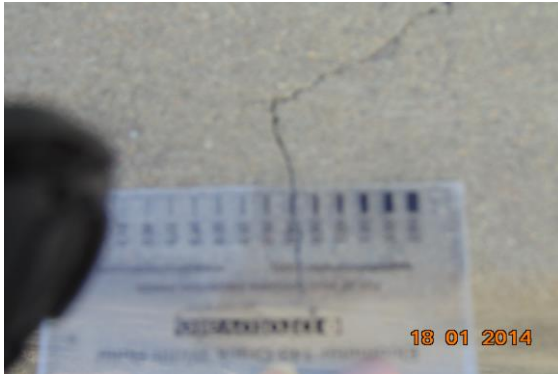
Photo 41

Inclined Crack on Wall No. 1 of Parapet Wall , Police H.Q.Terrace, Part A, Approx. Width = 0.6mm, Approx. Length = 1m.
Distance from Wall 4 = 20m, Height from Floor = 0m.

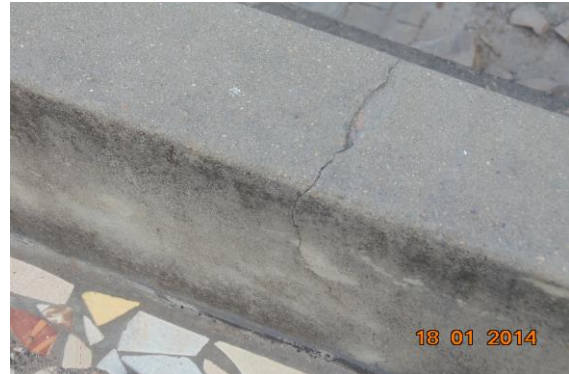
Photo 41A

Inclined Crack on Wall No. 1 of Parapet Wall , Police H.Q.Terrace, Part A, Approx. Width = 0.6mm, Approx. Length = 1m.
Distance from Wall 4 = 20m, Height from Floor = 0m.

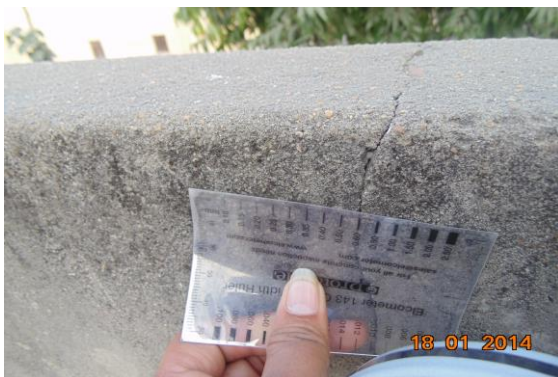
Photo 42

Inclined Crack on Wall No. 1 of Parapet Wall , Police H.Q.Terrace, Part A, Approx. Width = 0.6mm, Approx. Length = 0.8m.
Distance from Wall 4 = 10m, Height from Floor = 0m.

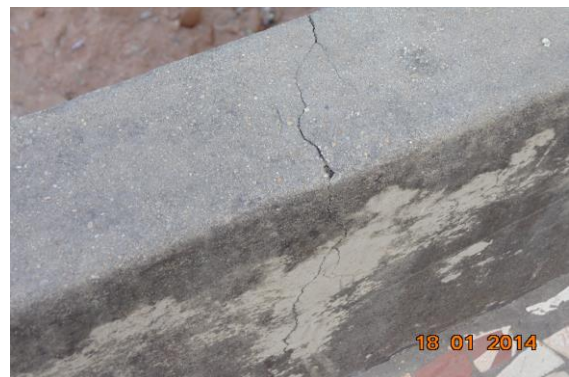
Photo 42A

Inclined Crack on Wall No. 1 of Parapet Wall , Police H.Q.Terrace, Part A, Approx. Width = 0.6mm, Approx. Length = 0.8m.
Distance from Wall 4 = 10m, Height from Floor = 0m.

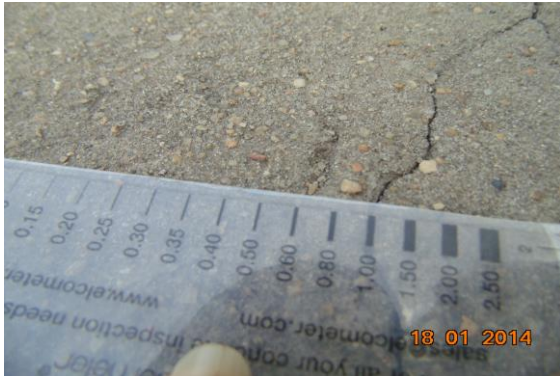
Photo 43

Inclined Crack on Wall No. 1 of Parapet Wall , Police H.Q.Terrace, Part A, Approx. Width = 1mm, Approx. Length = 1m.
Distance from wall 4 = 4m, Height from Floor = 0m.

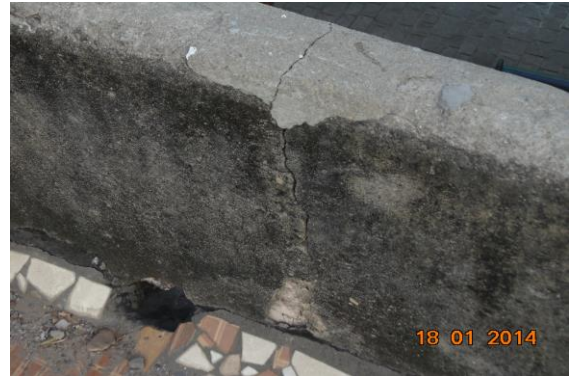
Photo 43A

Inclined Crack on Wall No. 1 of Parapet Wall , Police H.Q.Terrace, Part A, Approx. Width = 1mm, Approx. Length = 1m.
Distance from wall 4 = 4m, Height from Floor = 0m.

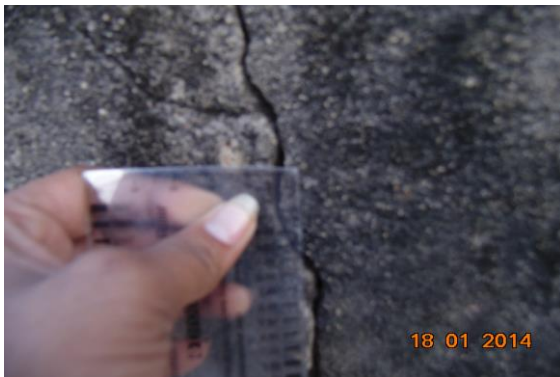
Photo 44

Inclined Crack on Wall No. 2 of Parapet Wall , Police H.Q.Terrace, Part A, Approx. Width = 5mm, Approx. Length = 1m.
Distance from Wall 3 = 15m, Height from Floor = 0m.

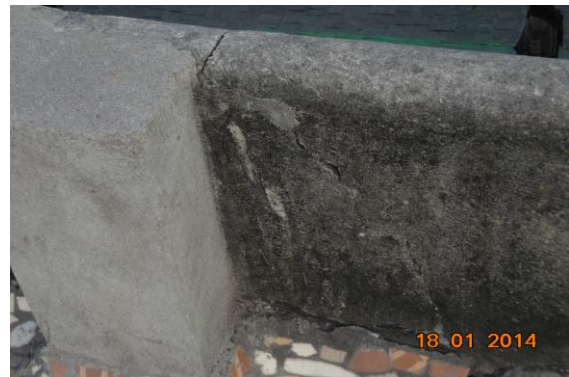
Photo 44A

Inclined Crack on Wall No. 2 of Parapet Wall , Police H.Q.Terrace, Part A, Approx. Width = 5mm, Approx. Length = 1m.
Distance from Wall 3 = 15m, Height from Floor = 0m.

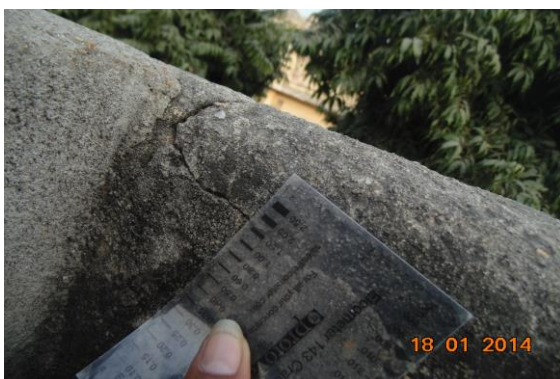
Photo 45

Inclined Crack on Wall No. 2 of Parapet Wall , Police H.Q.Terrace, Part A, Approx. Width = 1.5mm, Approx. Length = 1m.
Distance from Wall 3 = 10m, Height from Floor = 0m.

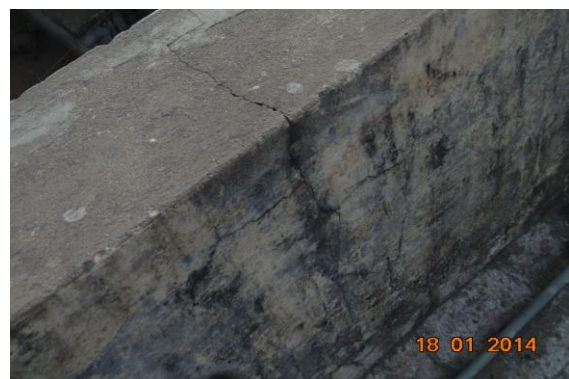
Photo 45A

Inclined Crack on Wall No. 2 of Parapet Wall , Police H.Q.Terrace, Part A, Approx. Width = 1.5mm, Approx. Length = 1m.
Distance from Wall 3 = 10m, Height from Floor = 0m.

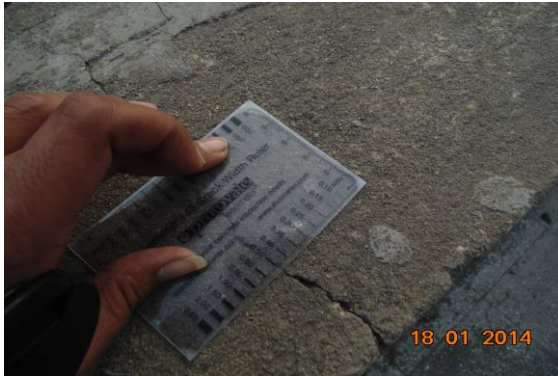
Photo 46

Inclined Crack on Wall No. 4 of Parapet Wall , Police H.Q.Terrace, Part A, Approx. Width = 0.5mm, Approx. Length = 1m.
Distance from Wall 2 = 2m, Height from Floor = 0m.

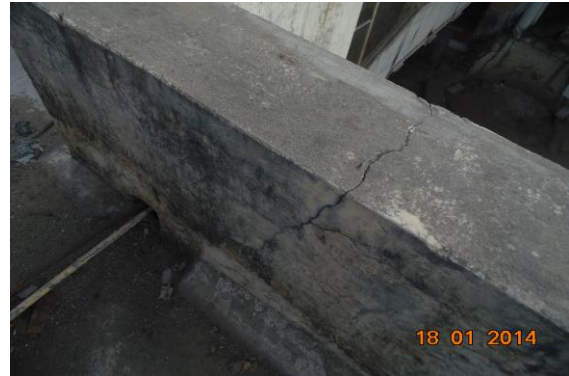
Photo 46A

Inclined Crack on Wall No. 4 of Parapet Wall , Police H.Q.Terrace, Part A, Approx. Width = 0.5mm, Approx. Length = 1m.
Distance from Wall 2 = 2m, Height from Floor = 0m.

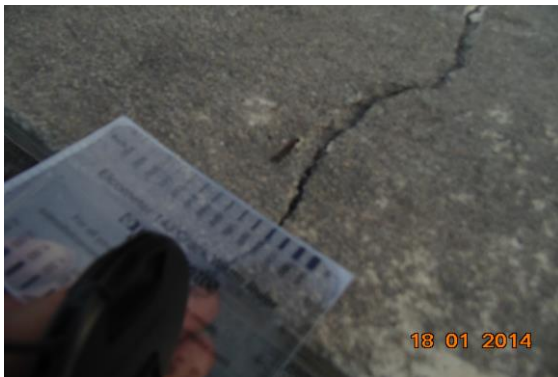
Photo 47

Inclined Crack on Wall No. 4 of Parapet Wall , Police H.Q.Terrace, Part A, Approx. Width = 0.4mm, Approx. Length = 1m.
Distance from Wall 1 = 2.6m, Height from Floor = 0m.

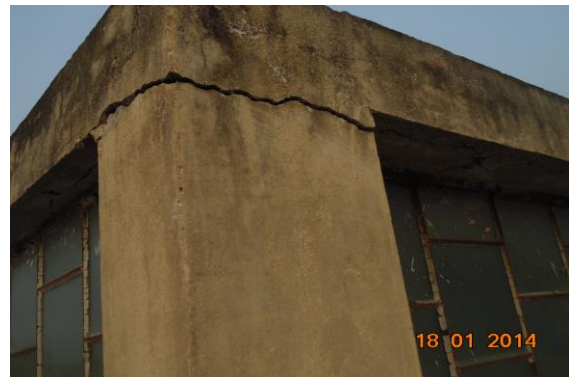
Photo 47A

Inclined Crack on Wall No. 4 of Parapet Wall , Police H.Q.Terrace, Part A, Approx. Width = 0.4mm, Approx. Length = 1m.
Distance from Wall 1 = 2.6m, Height from Floor = 0m.

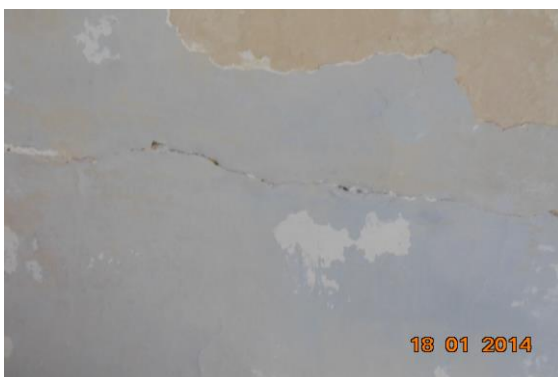
Photo 48

Horizontal Crack on Monty Wall of Minarets, Police H.Q.Terrace, Part A, Approx. Width = 10mm, Approx. Length = 0.5m.
Distance from Wall 3 = 4.5m, Height from Floor = 2m.

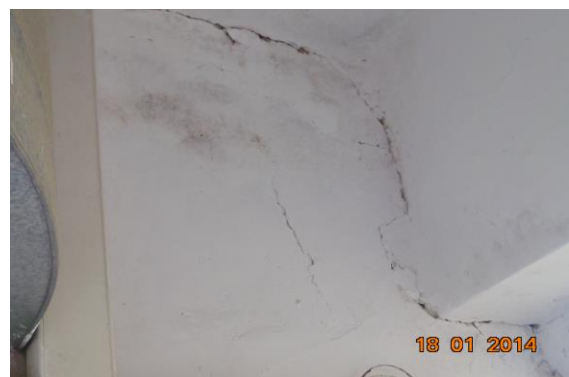
Photo 49

Horizontal Crack on Roof of Passage 2, Police H.Q. First Floor, Part C, Approx. Width = 3mm, Approx. Length = 2m.
Distance from Wall 4 = 1.3m, Height from Floor = 3m.

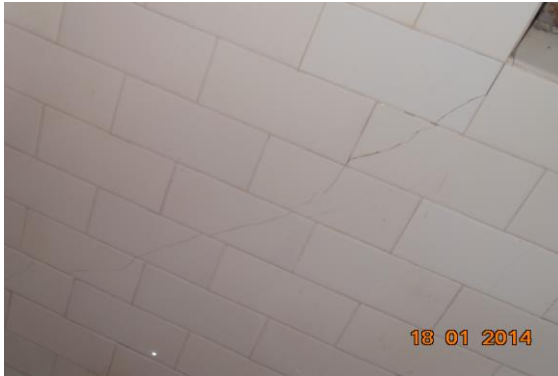
Photo 50

Vertical Crack on Roof of Passage 2, Police H.Q. First Floor, Part C, Approx. Width = 5mm, Approx. Length = 2m.
Distance from Wall 4 = 0m, Height from Floor = 3m.

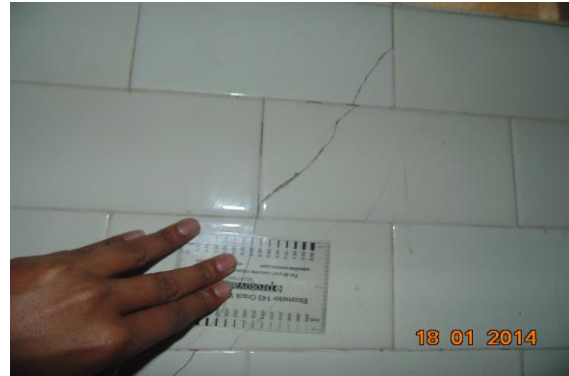
Photo 51

Inclined Crack on Wall No. 2 of Toilet No. 2, Police H.Q. First Floor, Part A, Approx. Width = 0.4mm, Approx. Length = 0.6m. Distance from Wall 4 = 0m, Height from Floor = 0.3m.

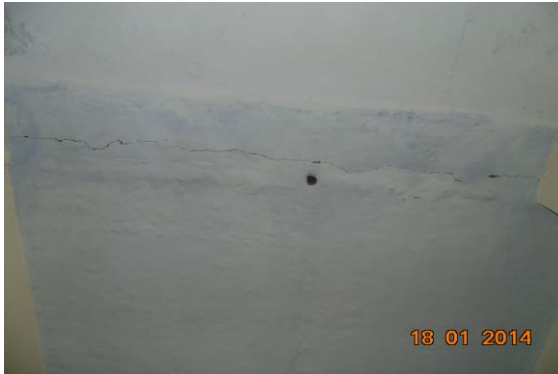
Photo 51A

Inclined Crack on Wall No. 2 of Toilet No. 2, Police H.Q. First Floor, Part A, Approx. Width = 0.4mm, Approx. Length = 0.6m. Distance from Wall 4 = 0m, Height from Floor = 0.3m.

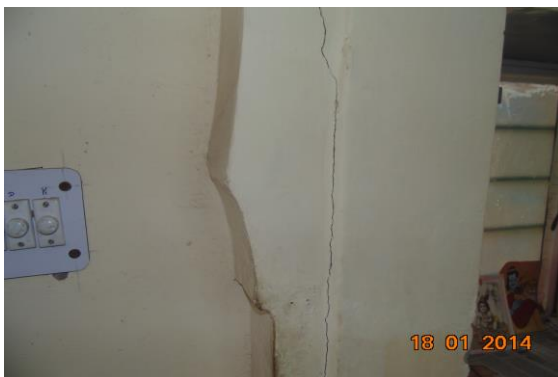
Photo 53

Vertical Crack on Wall No. 3 of Room No. 398, Police H.Q. First Floor, Part A, Approx. Width = 1mm, Approx. Length = 1.3m. Distance from Wall 1 = 3m, Height from Floor = 0.2m.

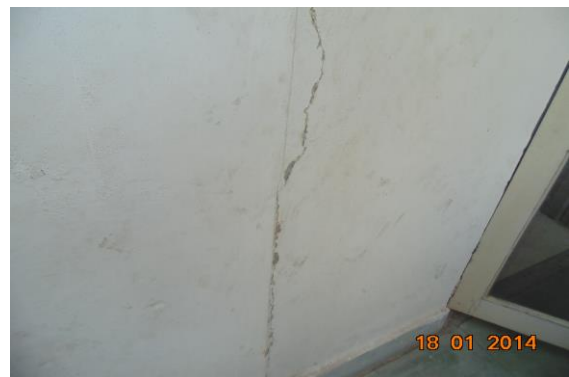
Photo 53A

Vertical Crack on Wall No. 3 of Room No. 398, Police H.Q. First Floor, Part A, Approx. Width = 1mm, Approx. Length = 1.3m. Distance from Wall 1 = 3m, Height from Floor = 0.2m.

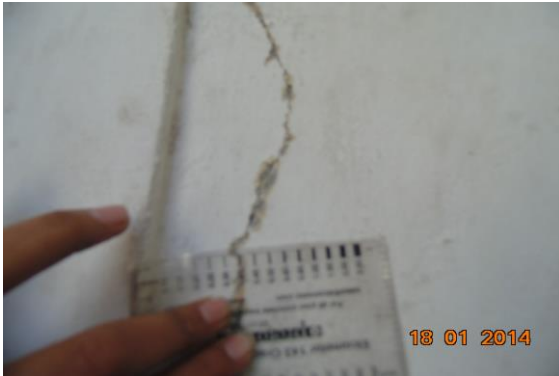
Photo 54

Inclined Crack on Wall No. 1 of Balcony 1, Police H.Q. First Floor, Part A, Approx. Width = 0.35mm, Approx. Length = 1.5m. Distance from Door of Room No. 399 = 0.6m, Height from Floor = 0m.

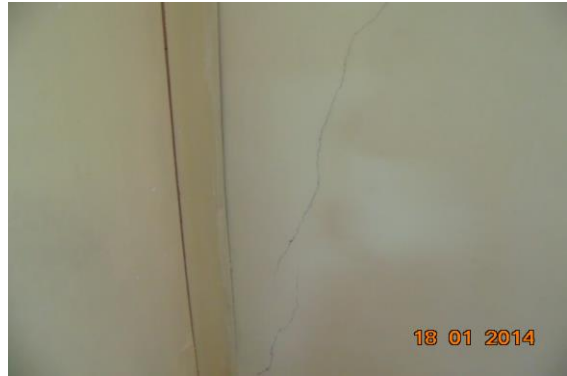
Photo 54A

Inclined Crack on Wall No. 1 of Balcony 1, Police H.Q. First Floor, Part A, Approx. Width = 0.35mm, Approx. Length = 1.5m. Distance from Door of Room No. 399 = 0.6m, Height from Floor = 0m.

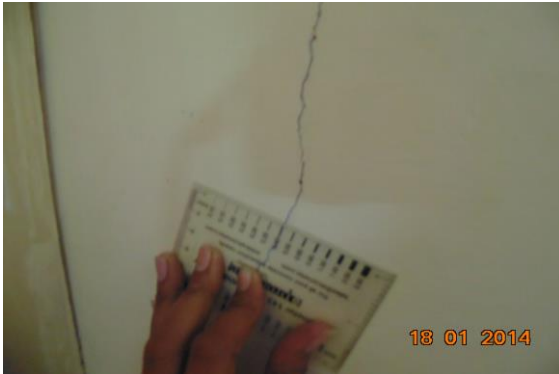
Photo 55

Inclined Crack on Wall No. 4 of Room No. 399, Part B, Police H.Q. First Floor, Part A, Approx. Width = 0.4mm, Approx. Length = 1m. Distance from Wall 1 = 0m, Height from Floor = 1m.

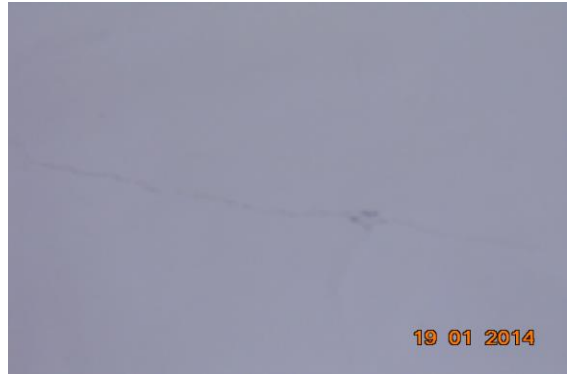
Photo 55A

Inclined Crack on Wall No. 4 of Room No. 399, Part B, Police H.Q. First Floor, Part A, Approx. Width = 0.4mm, Approx. Length = 1m. Distance from Wall 1 = 0m, Height from Floor = 1m.

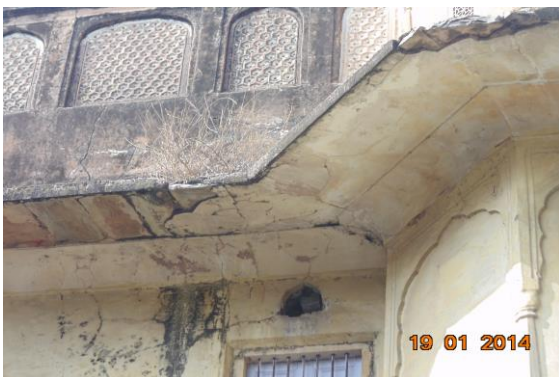
Photo 56

Inclined Crack on Wall No. 3 of Passage 2, Police H.Q. First Floor, Part E, Approx. Width = 0.4mm, Approx. Length = 0.6m. Distance from Wall 1 = 2m, Height from Floor = 2.3m.

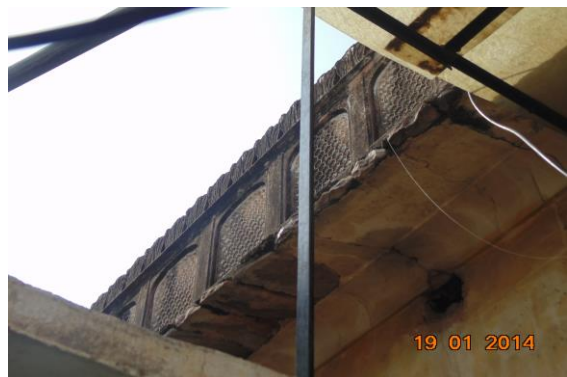
Photo 57

Peeling of Plaster on Shade of Police H.Q. First Floor, Part B

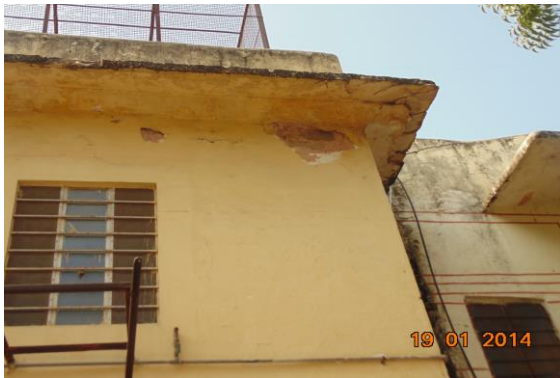
Photo 59

Peeling of Plaster on Shade of External Façade Front Gate, Left Side of First Floor, Police H.Q.

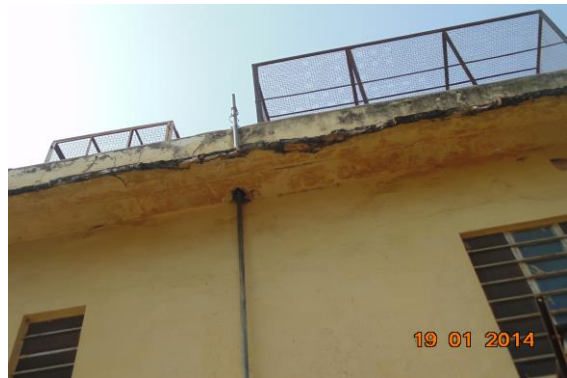
Photo 60

Peeling of Plaster on Shade of External Façade Front Gate, Left Side of First Floor, Police H.Q.

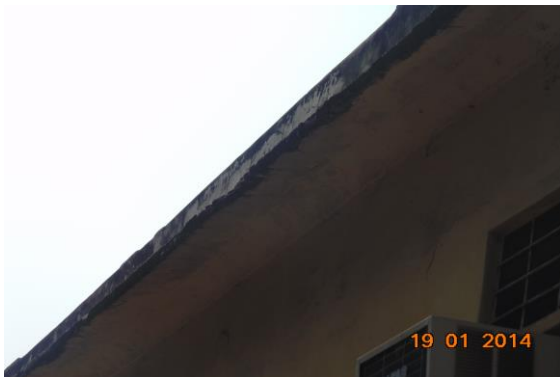
Photo 61

Peeling of Plaster on Shade of External Façade Front Gate, Left Side of First Floor, Police H.Q.

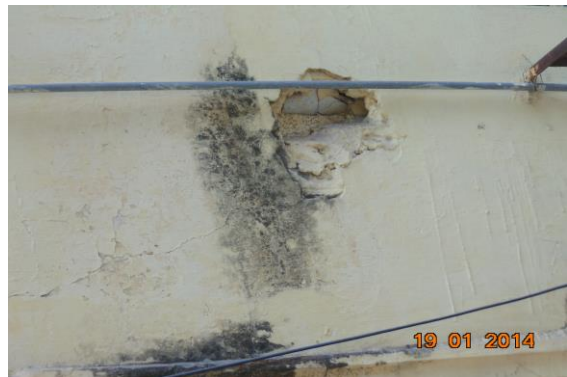
Photo 62

Peeling of Plaster on Outer Wall of External Façade Front Gate of First Floor, Police H.Q.

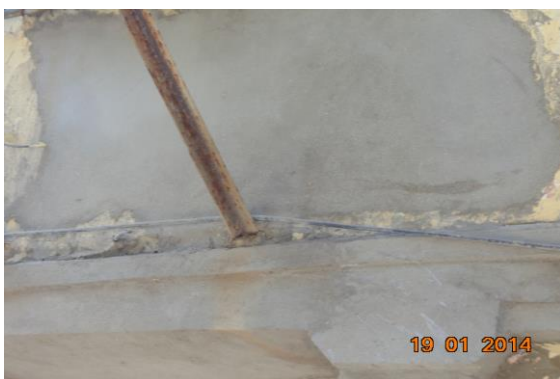
Photo 63

Peeling of Plaster on Outer Wall of External Façade Front Gate of Ground Floor, Police H.Q.

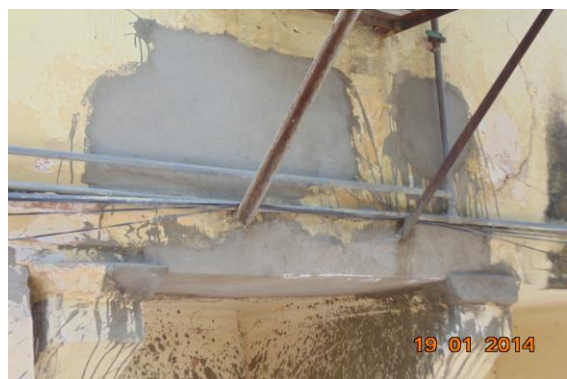
Photo 64

Peeling of Plaster on Outer Wall of External Façade Front Gate of First Floor, Police H.Q.

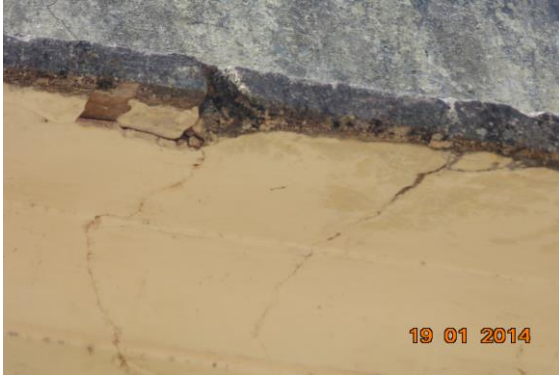
Photo 65

Peeling of Plaster on Shade of Outer Wall of External Façade Front Gate of First Floor , Police H.Q.

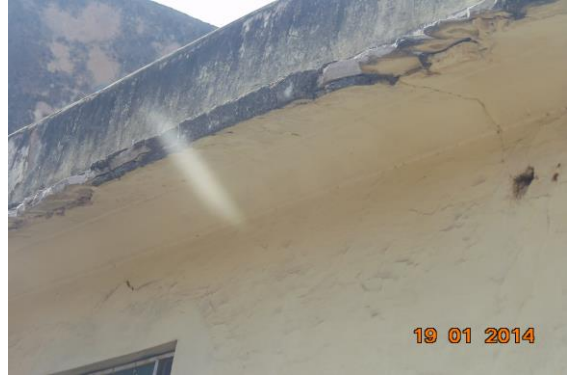
Photo 66

Peeling of Plaster on Shade of Outer Wall of External Façade Front Gate of First Floor , Police H.Q.

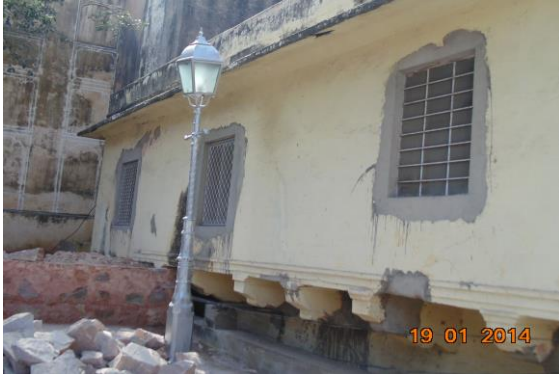
Photo 67

Peeling of Plaster on Outer Wall of Window of External Façade Front Gate of Ground Floor , Police H.Q.

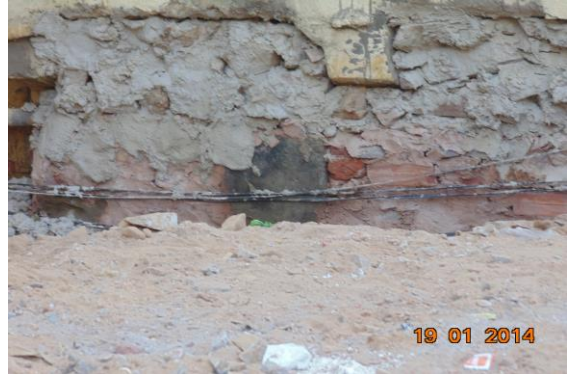
Photo 68

Peeling of Plaster on Outer Wall of From Hawa Mahal of Ground Floor , Police H.Q.

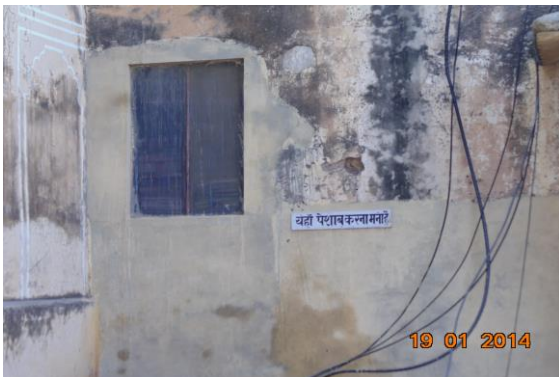
Photo 69

Peeling of Plaster on Outer Wall of From Hawa Mahal of Ground Floor , Police H.Q.

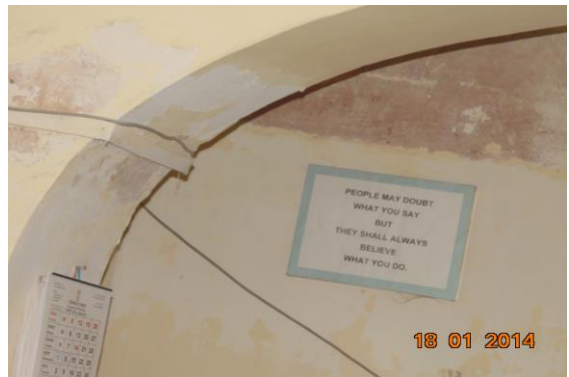
Photo 70

Peeling of Plaster on Wall No. 4 of Room No. 213 of Police H.Q. Ground Floor, Part A

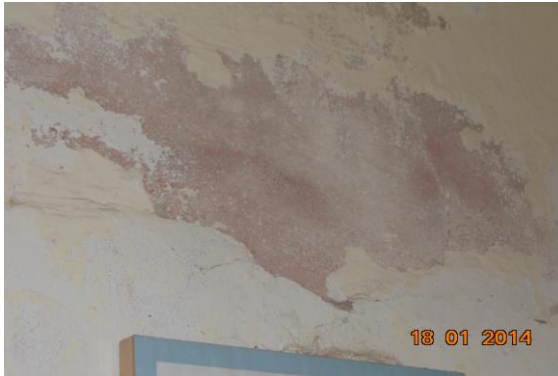
Photo 71

Peeling of Plaster on Wall No. 4 of Room No. 213 of Police H.Q. Ground Floor, Part A

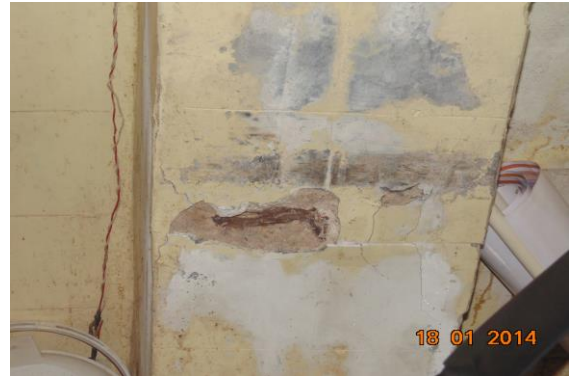
Photo 72

Dampness/Seepage on Wall No. 1 of Room No. 213 of Police H.Q. Ground Floor, Part A

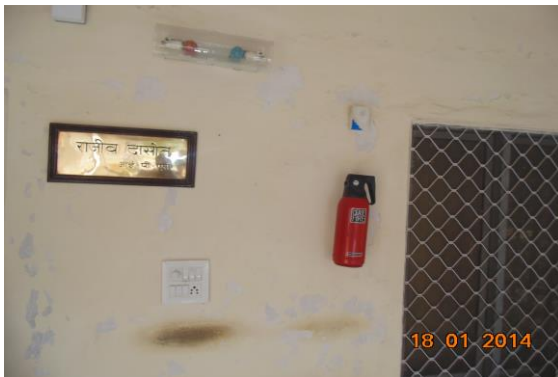
Photo 73

Peeling of Plaster on Wall No. 4 of Varanda 2 of Police H.Q. Ground Floor, Part A

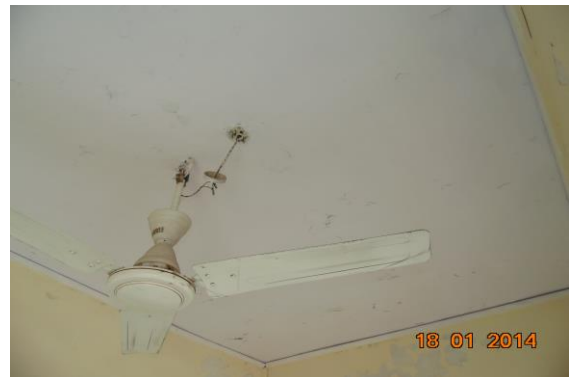
Photo 74

Peeling of Plaster on Roof of Varanda 3 of Police H.Q. Ground Floor, Part A

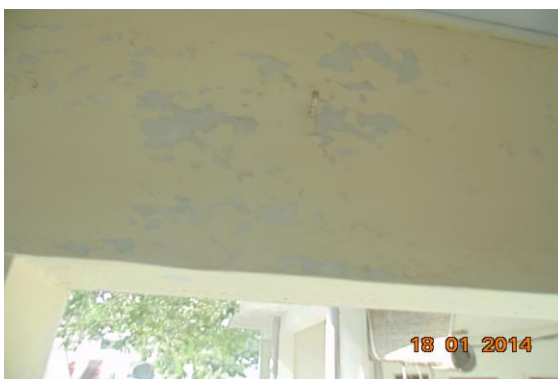
Photo 75

Peeling of Plaster on Wall No. 3 of Varanda 4 of Police H.Q. Ground Floor, Part A

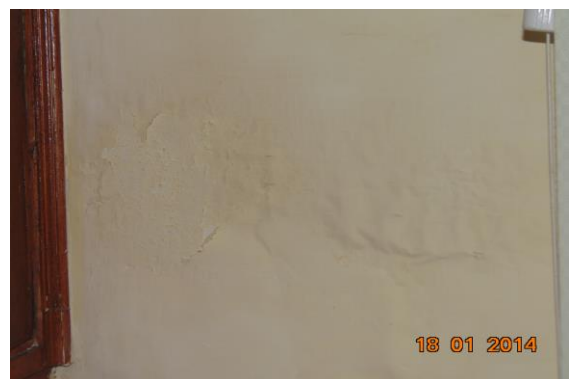
Photo 76

Peeling of Plaster on Wall No. 4 of Room No. 212 of Police H.Q. Ground Floor, Part A

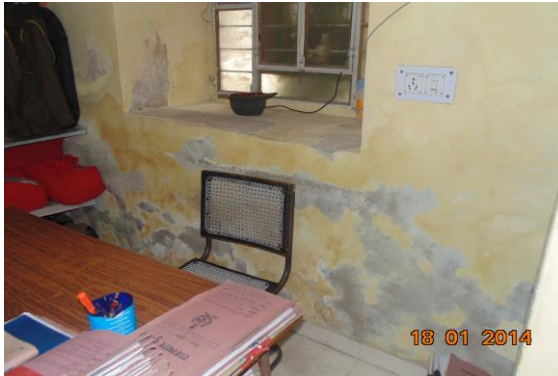
Photo 77

Peeling of Plaster on Wall No. 2 of Room No. 211, Part D of Police H.Q. Ground Floor, Part A

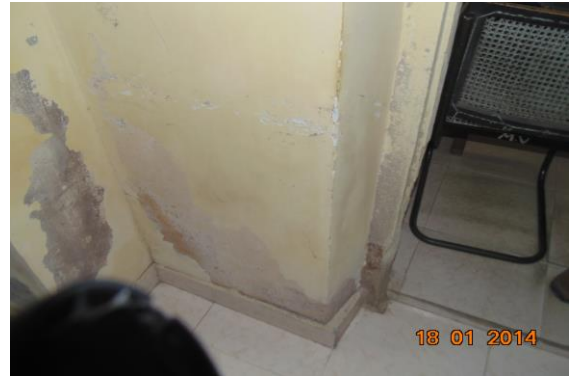
Photo 78

Peeling of Plaster on Wall No. 3 of Room No. 211, Part D of Police H.Q. Ground Floor, Part A

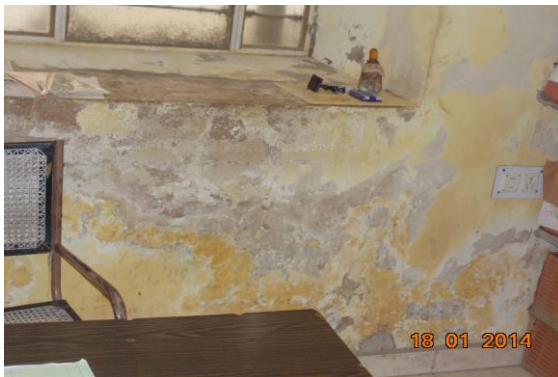
Photo 79

Peeling of Plaster on Wall No. 4 of Room No. 211, Part A of Police H.Q. Ground Floor, Part A

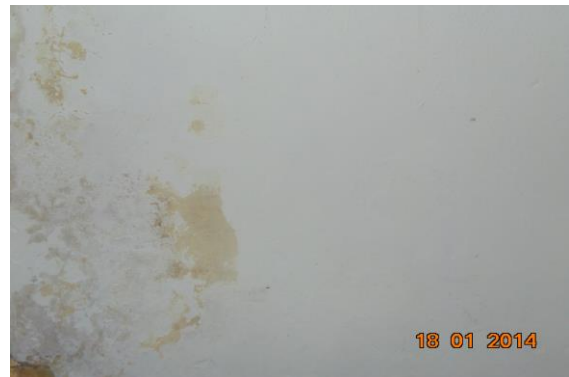
Photo 80

Dampness/Seepage on Roof of Room No. 211, Part C of Police H.Q. Ground Floor, Part A

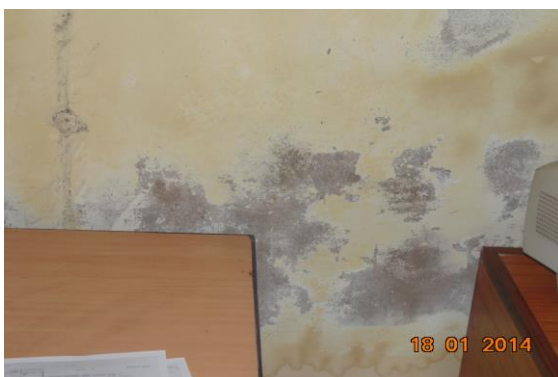
Photo 81

Peeling of Plaster on Wall No. 1 of Room No. 210 of Police H.Q. Ground Floor, Part A

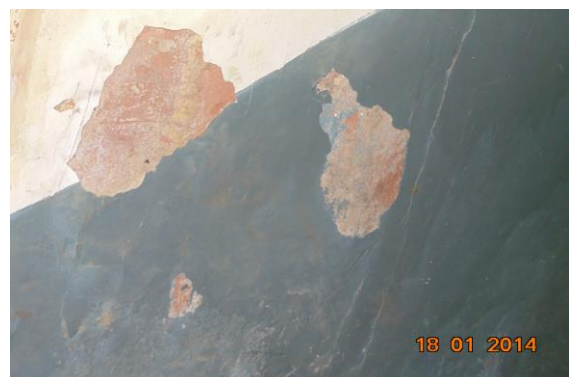
Photo 82

Peeling of Plaster on Wall No. 4 of Passage 1 of Police H.Q. Ground Floor, Part A

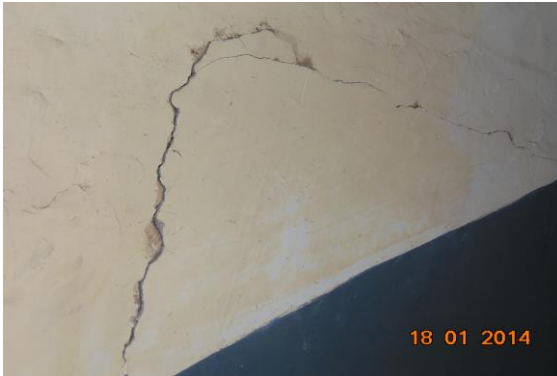
Photo 83

Peeling of Plaster on Wall No. 1 of Stair 2 of Police H.Q. Ground Floor, Part A

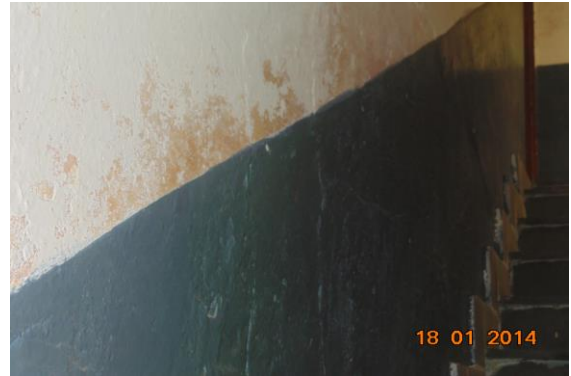
Photo 84

Peeling of Plaster on Wall No. 1 of Stair 2 of Police H.Q. Ground Floor, Part A

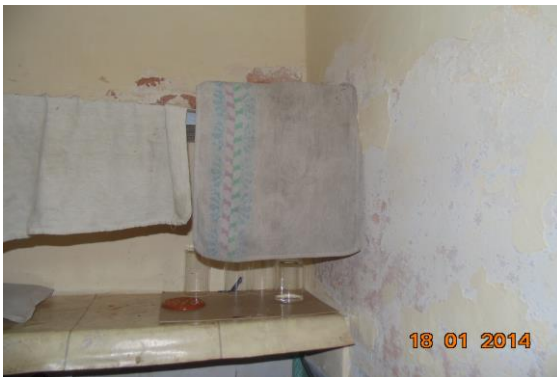
Photo 85

Peeling of Plaster on Wall No. 2 & 4 of Room No. 209 of Police H.Q. Ground Floor, Part A

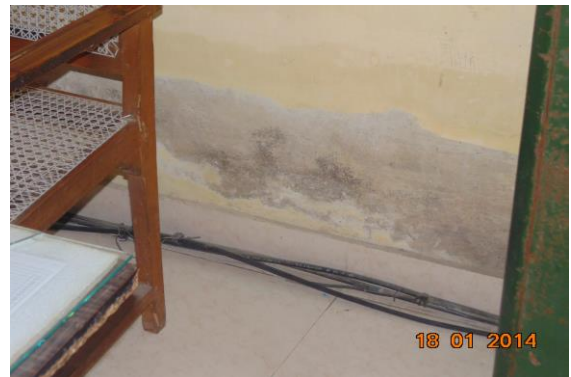
Photo 86

Peeling of Plaster on Wall No. 2 of Room No. 413 of Police H.Q. Ground Floor, Part A

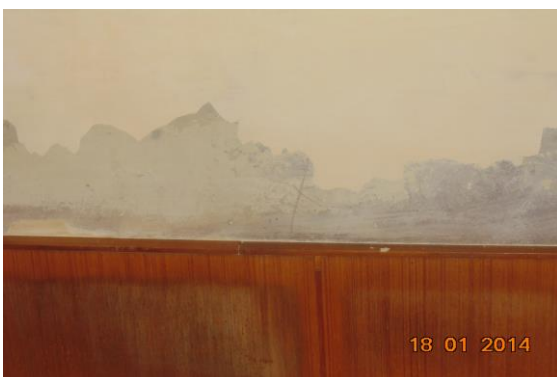
Photo 87

Peeling of Plaster on Wall No. 1 of Room No. 414 of Police H.Q. Ground Floor, Part A

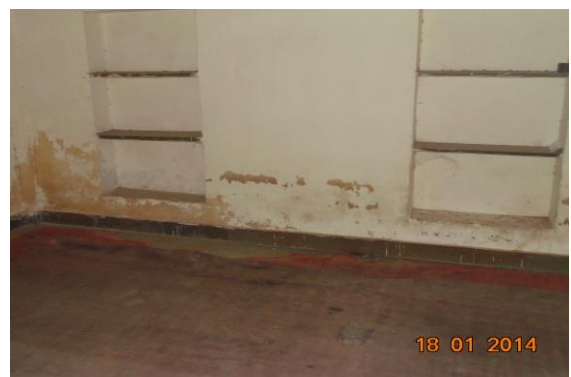
Photo 88

Peeling of Plaster on Wall No. 4 of Rest Room of Police H.Q. Ground Floor, Part A

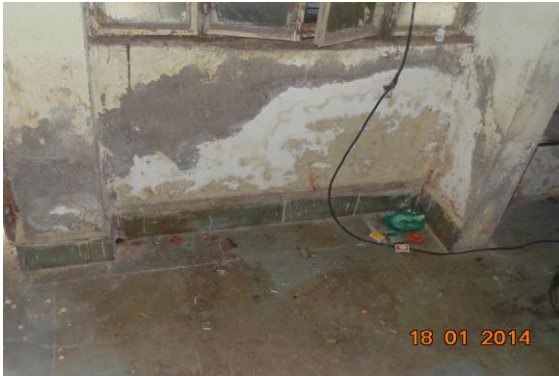
Photo 89

Dampness/Seepage on Wall No. 3 of Rest Room of Police H.Q. Ground Floor, Part A

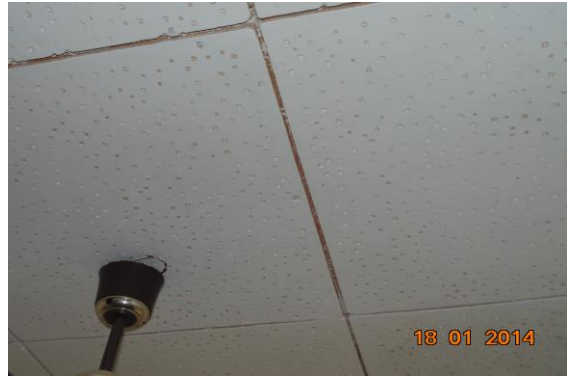
Photo 90

Peeling of Plaster on Roof of Room No. 405 of Police H.Q. Ground Floor, Part B

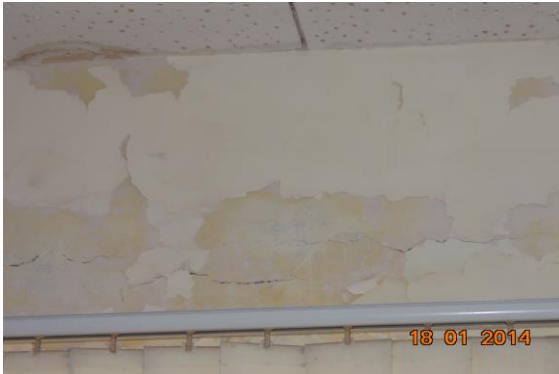
Photo 91

Plaster Crack on Wall No. 4 of Room No. 405 of Police H.Q. Ground Floor, Part B

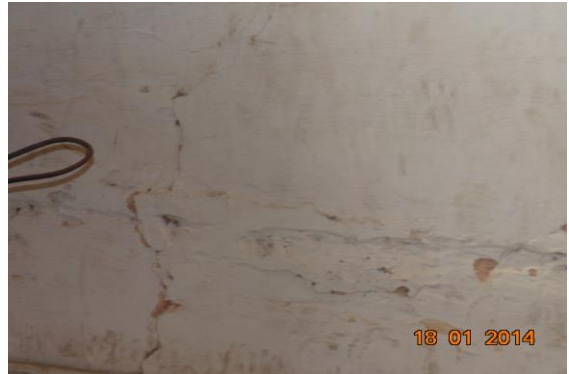
Photo 92

Peeling of Plaster on Wall No. 1 of Passage 3 of Police H.Q. Ground Floor, Part B

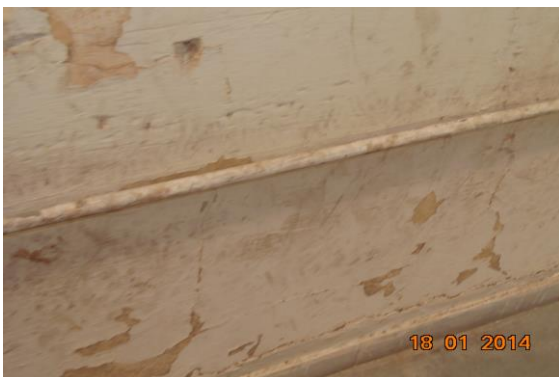
Photo 93

Peeling of Plaster on Wall No. 1 of Passage 3 of Police H.Q. Ground Floor, Part B

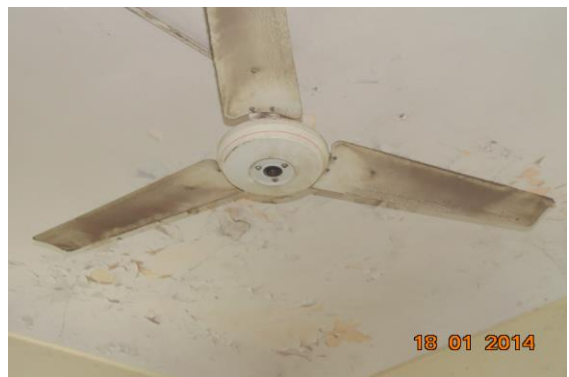
Photo 94

Dampness/Seepage on Roof of Room No. 101 of Police H.Q. Ground Floor, Part A

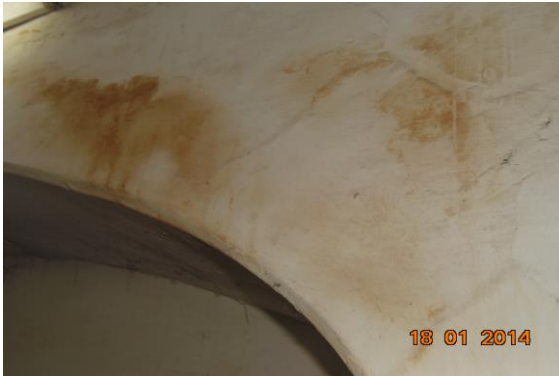
Photo 95

Dampness/Seepage on Wall No. 1 of Room No. 210, Part A of Police H.Q. Ground Floor, Part A

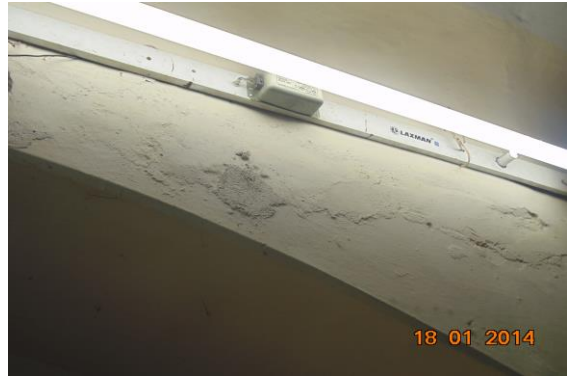
Photo 96

Peeling of Plaster on Wall No. 3 of Room No. 210, Part B of Police H.Q. Ground Floor, Part A

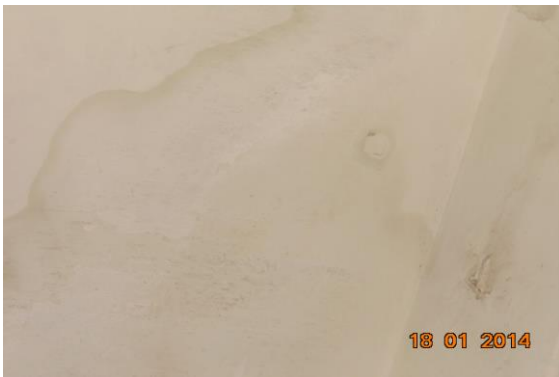
Photo 97

Dampness/Seepage on Wall No. 4 of Room No. 210, Part C of Police H.Q. Ground Floor, Part A

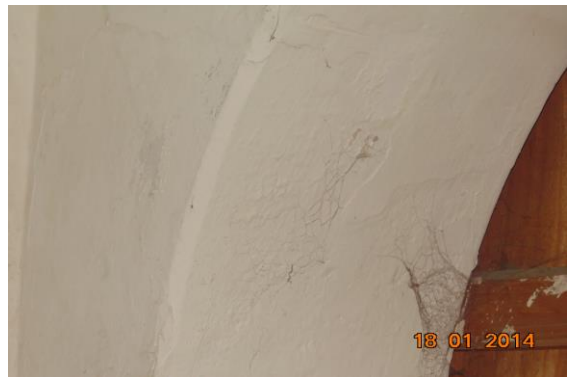
Photo 98

Peeling of Plaster on Wall No. 3 of Room No. 210, Part C of Police H.Q. Ground Floor, Part A

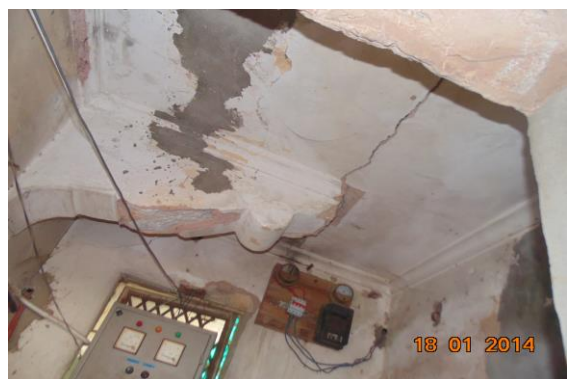
Photo 99

Peeling of Plaster on Wall No. 1 of Room No. 216 of Police H.Q. Ground Floor, Part A

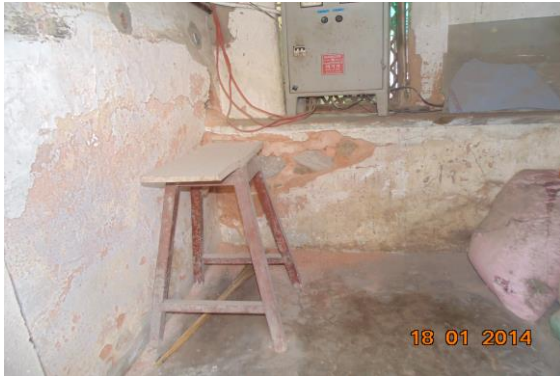
Photo 100

Damaged Portion on Roof of Store 1 of Police H.Q. Ground Floor, Part A

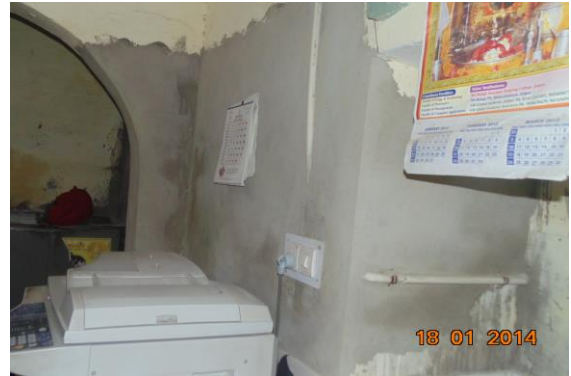
Photo 101

Peeling of Plaster on Wall No. 1 & 4 of Store 1 of Police H.Q. Ground Floor, Part A

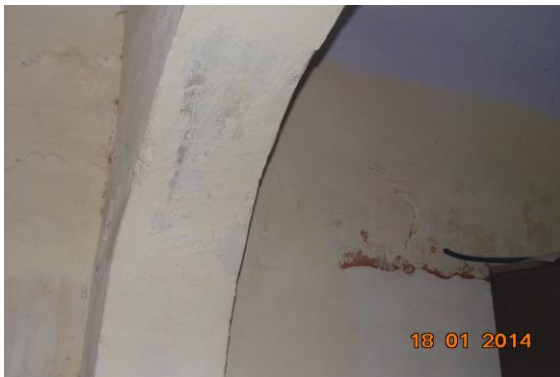
Photo 102

Peeling of Plaster on Wall No. 3 of Room No. 215 of Police H.Q. Ground Floor, Part A

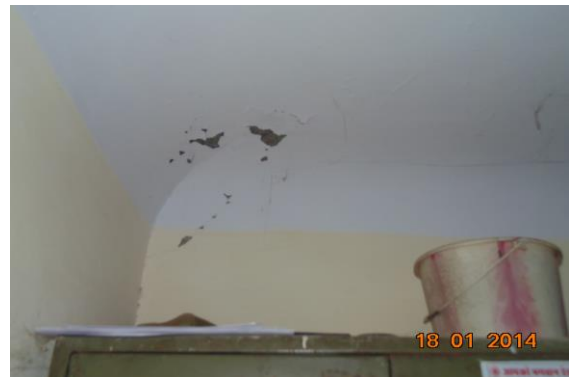
Photo 103

Peeling of Plaster on Wall No. 4 of Room No. 215 of Police H.Q. Ground Floor, Part A

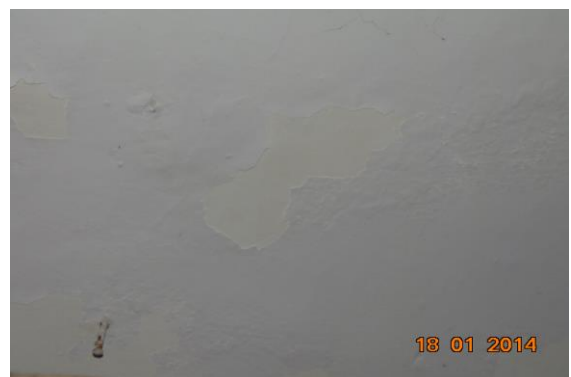
Photo 105

Peeling of Plaster on Wall No. 2 of Room No. 214 of Police H.Q. Ground Floor, Part A

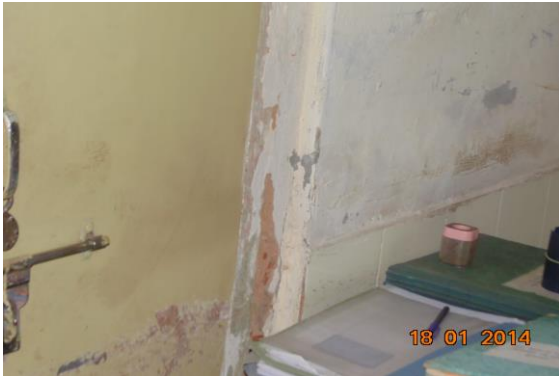
Photo 106

Peeling of Plaster on Roof of Room No. 214 of Police H.Q. Ground Floor, Part A

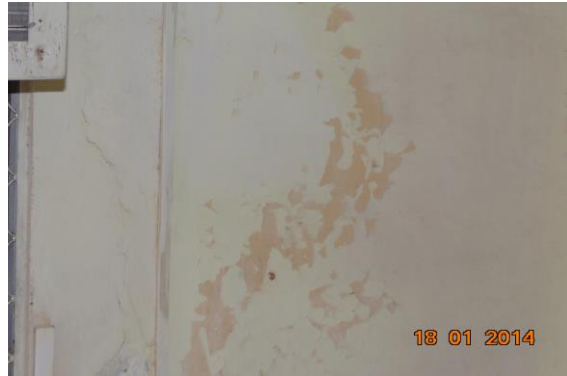
Photo 107

Peeling of Plaster on Wall No. 1 of Room No. 214 of Police H.Q. Ground Floor, Part A

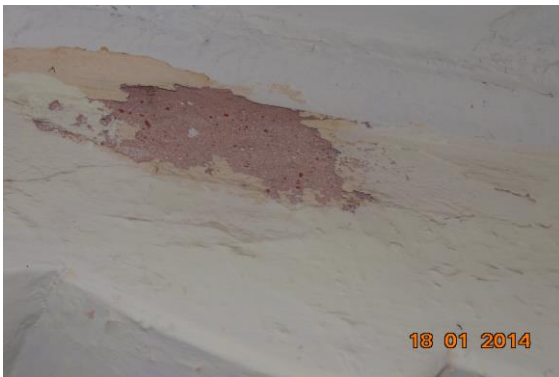
Photo 108

Peeling of Plaster on Wall No. 1 of Varanda 1 of Police H.Q. Ground Floor, Part A
