Pre Building Condition Survey Report

Name and Address of Structure :	Choti Chopar to Badi Chopar (UP Line)
---------------------------------	---------------------------------------

Name of the Project	Contract JMRC-UG1B “Design and Construction of Tunnel between Chandpole and Badi Chouper and reverse line by Shield TBM, Underground Metro Stations at Choti Chouper and Badi Chouper by Cut and Cover Methods on East West Corridor of Jaipur Metro Rail Corporation Limited .”	
Owner :

Shoping Complex - Shop No. 169-188
Tripolia Bazar
Jaipur
Unique ID: CC BC UP 0001

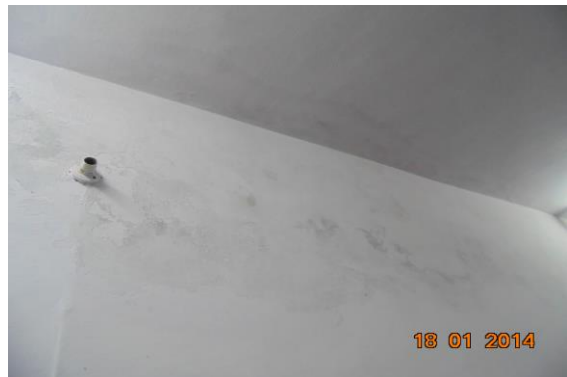
Photo 109

Peeling of Plaster on Roof of Varanda 1 of Police H.Q. Ground Floor, Part A

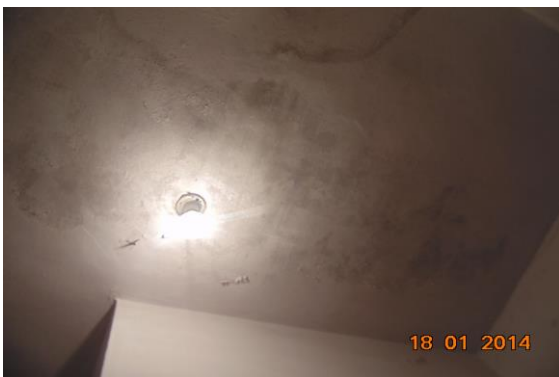
Photo 110

Dampness/Seepage on Wall No. 4 & Roof of Room No, 301 of Police H.Q. First Floor, Part B

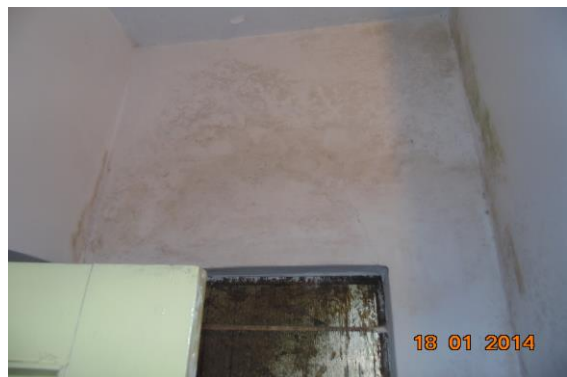
Photo 111

Dampness/Seepage on Roof of Toilet No. 1 of Police H.Q. Ground Floor, Part B

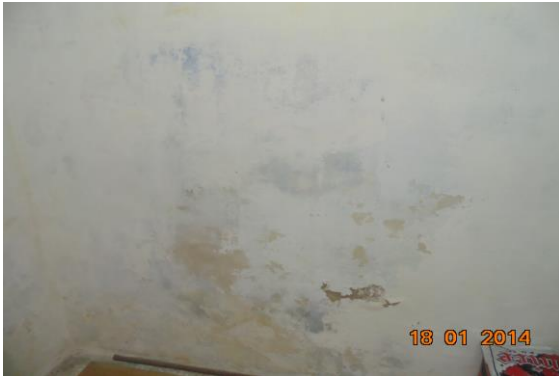
Photo 112

Dampness/Seepage on Wall No. 2 of Toilet No. 1 of Police H.Q. Ground Floor, Part B

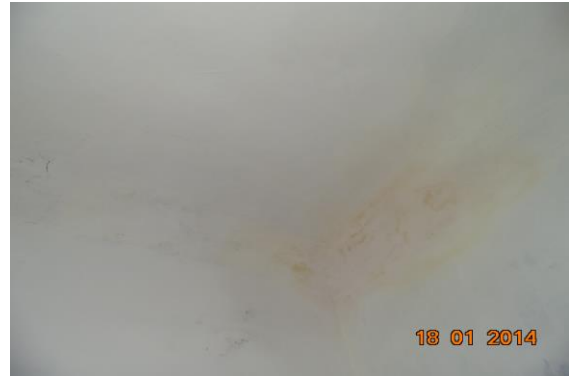
Photo 113

Dampness/Seepage on Wall No. 4 of Room No, 301, Part A of Police H.Q. Ground Floor, Part A

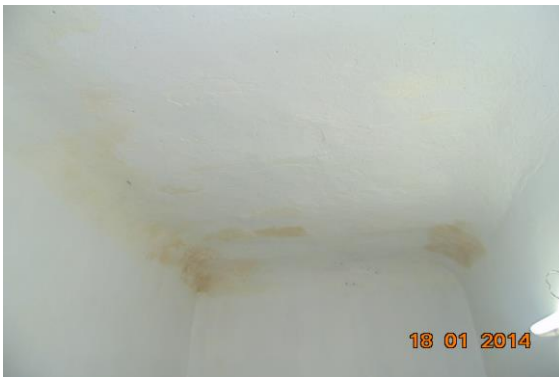
Photo 114

Dampness/Seepage on Roof of Room No, 301, Part A of Police H.Q. Ground Floor, Part A

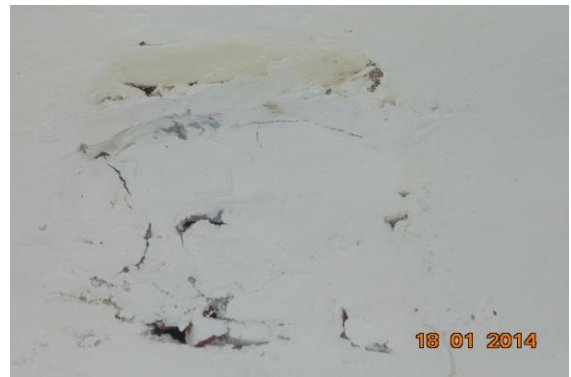
Photo 115

Dampness/Seepage on Roof of Room No, 301, Part B of Police H.Q. Ground Floor, Part A

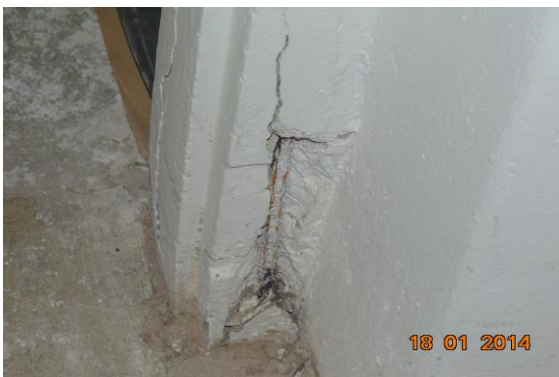
Photo 116

Damaged Portion on Wall No. 3 of Room No, 301, Part B of Police H.Q. Ground Floor, Part A

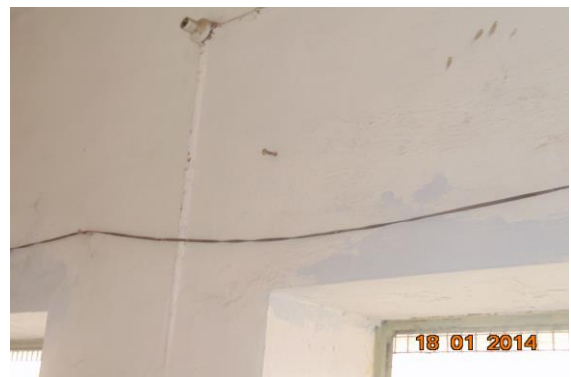
Photo 117

Damaged Portion on Wall No. 3 of Room No, 301, Part B of Police H.Q. Ground Floor, Part A

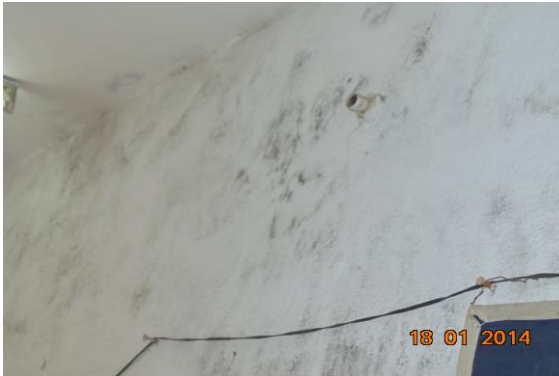
Photo 118

Dampness/Seepage on Wall No. 2 of Passage 1 of Police H.Q. Ground Floor, Part A

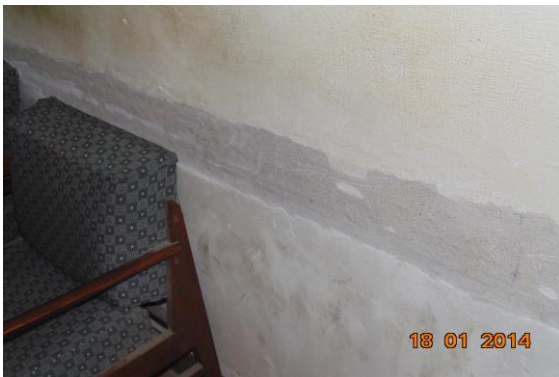
Photo 120

Dampness/Seepage on Wall No. 4 of Room No. 302 of Police H.Q. Ground Floor, Part B

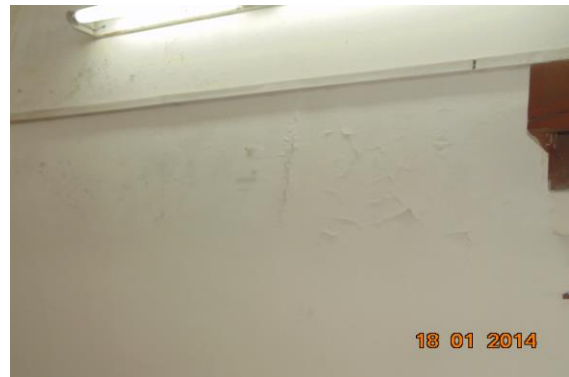
Photo 121

Peeling of Plaster on Wall No. 2 of Room No. 302 of Police H.Q. Ground Floor, Part B

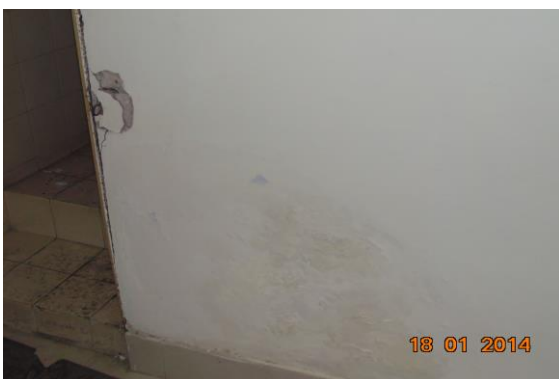
Photo 122

Dampness/Seepage on Wall No. 2 of Room No. 303 of Police H.Q. Ground Floor, Part B

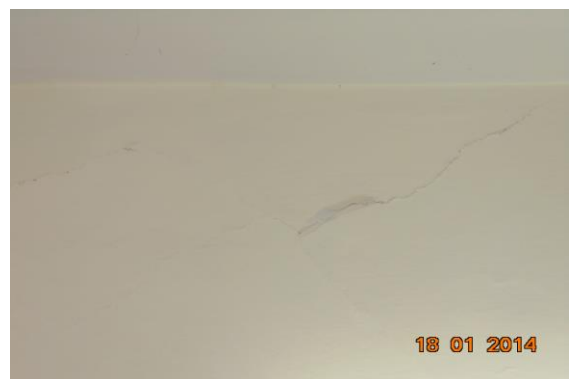
Photo 123

Dampness/Seepage on Wall No. 2 of Room No. 303 of Police H.Q. Ground Floor, Part B

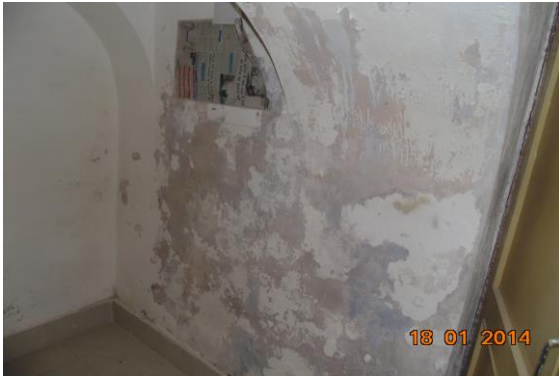
Photo 124

Plaster Crack on Wall No. 4 of Room No. 303 of Police H.Q. Ground Floor, Part B

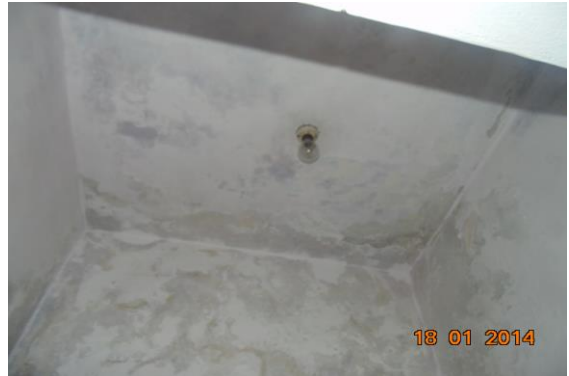
Photo 125

Dampness/Seepage on Wall No. 2 of Room No. 303 of Police H.Q. Ground Floor, Part B

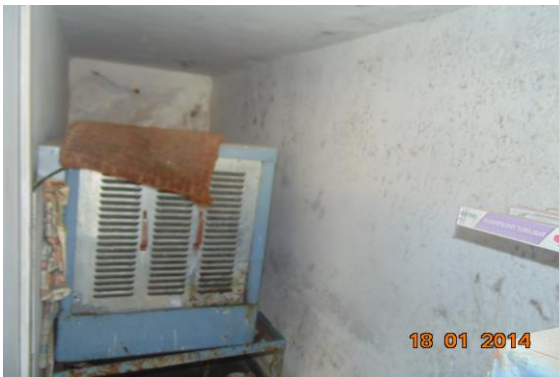
Photo 126

Dampness/Seepage on Wall No. 1, 2, 4 & Roof of Toilet No. 2 of Police H.Q. Ground Floor, Part B

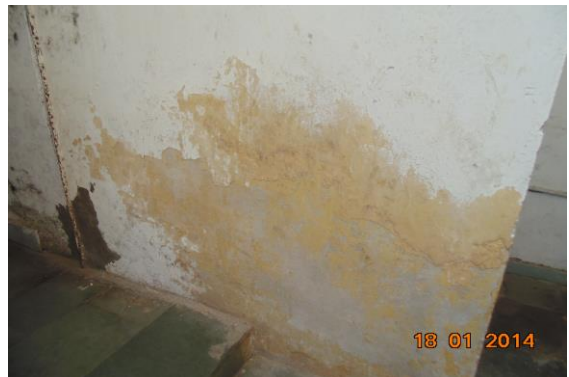
Photo 127

Dampness/Seepage on Wall No. 1, 4 & Roof of Store 1 of Police H.Q. Ground Floor, Part B

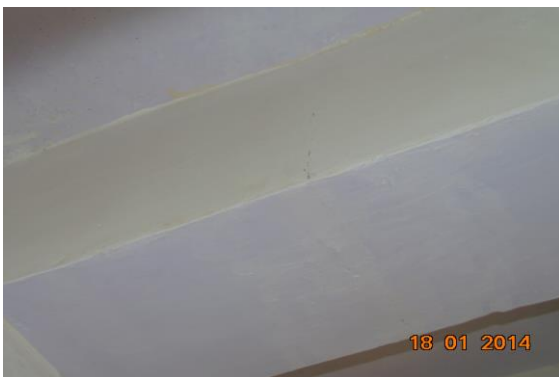
Photo 128

Peeling of Plaster on Wall No. 4 of Passage 2 of Police H.Q. Ground Floor, Part B

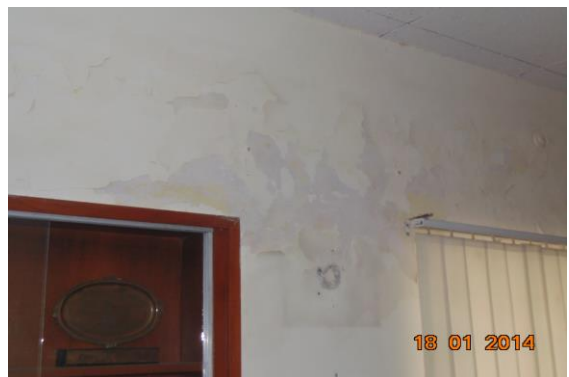
Photo 129

Plaster Crack on Roof of Toilet No. 3 of Police H.Q. Ground Floor, Part B

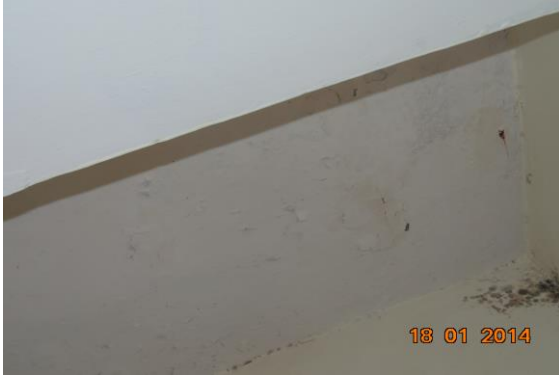
Photo 130

Peeling of Plaster on Wall No. 1 of Room No. 405 of Police H.Q. Ground Floor, Part B

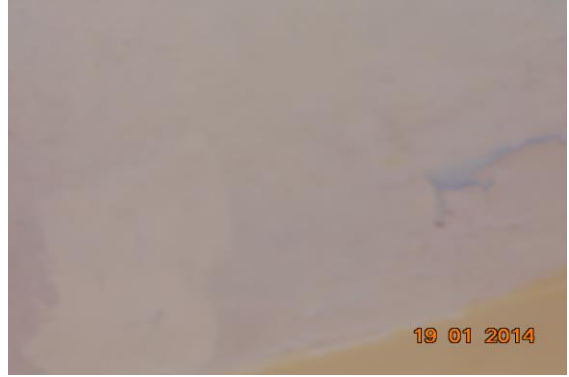
Photo 131

Peeling of Plaster on Roof of Toilet No. 4 of Police H.Q. Ground Floor, Part B

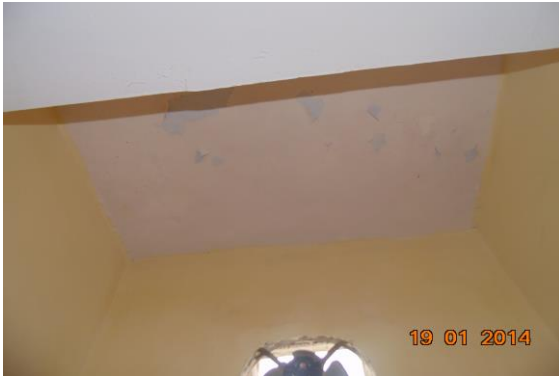
Photo 132

Dampness/Seepage on Roof of Room No. 403 of Police H.Q. Ground Floor, Part B

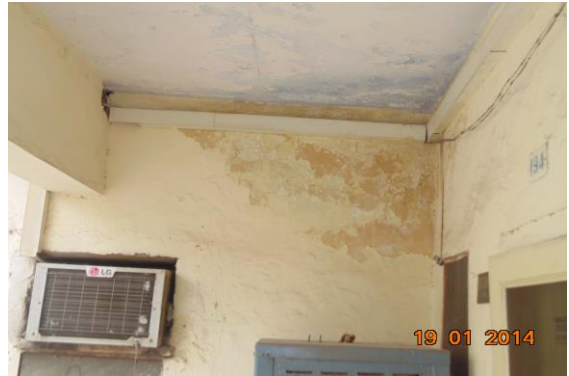
Photo 133

Dampness/Seepage on Roof of Toilet No. 5 of Police H.Q. Ground Floor, Part B

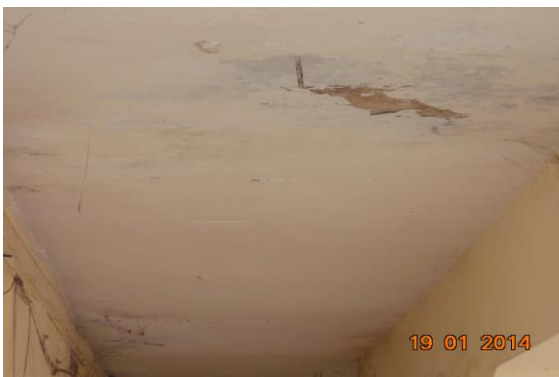
Photo 134

Dampness/Seepage on Wall No. 1 & Roof of Varanda 2 of Police H.Q. Ground Floor, Part C

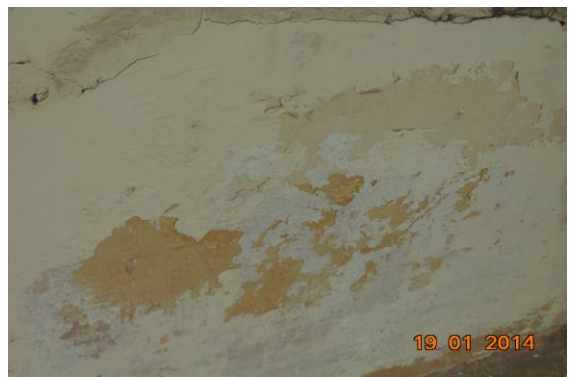
Photo 135

Dampness/Seepage on Roof of Varanda 2 of Police H.Q. Ground Floor, Part C

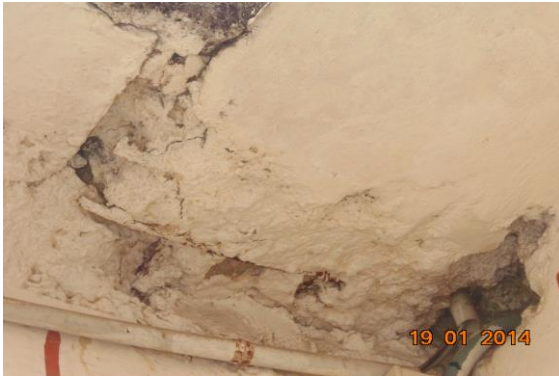
Photo 136

Peeling of Plaster on Wall No. 4 of Varanda 2 of Police H.Q. Ground Floor, Part C

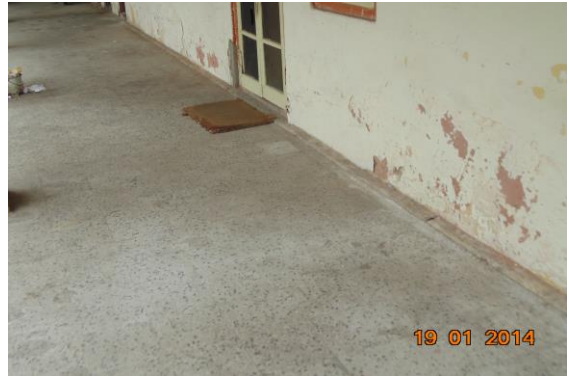
Photo 137

Peeling of Plaster on Shade of Varanda 2 of Police H.Q. Ground Floor, Part C

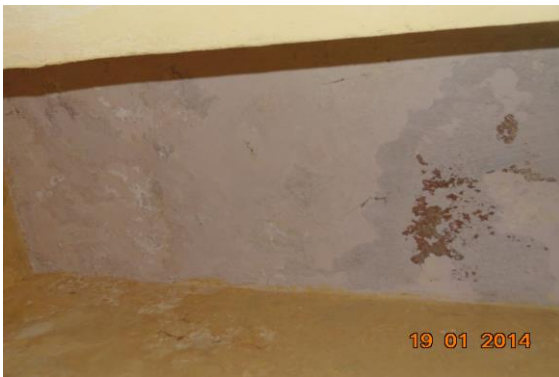
Photo 138

Peeling of Plaster on Wall No. 4 of Varanda 1 of Police H.Q. Ground Floor, Part C

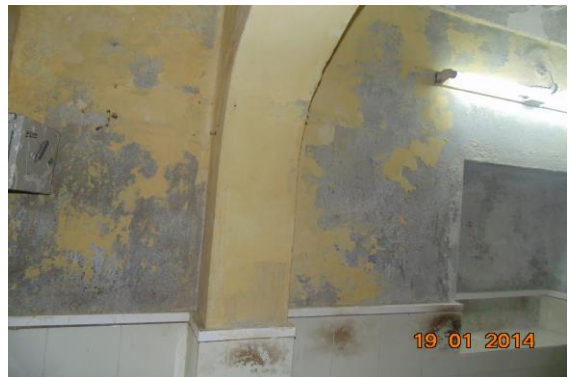
Photo 139

Dampness/Seepage on Wall No. 3 & Roof of Reception Room of Police H.Q. Ground Floor, Part A

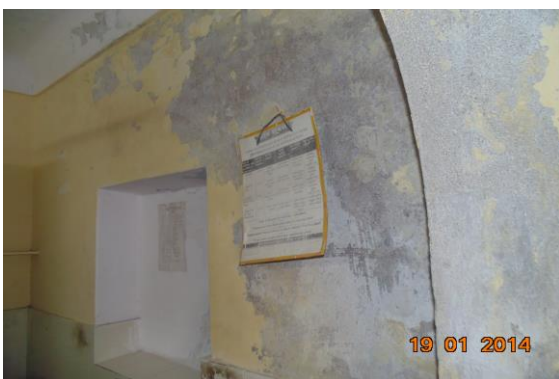
Photo 140

Dampness/Seepage on Wall No. 1 of Reception Room of Police H.Q. Ground Floor, Part A

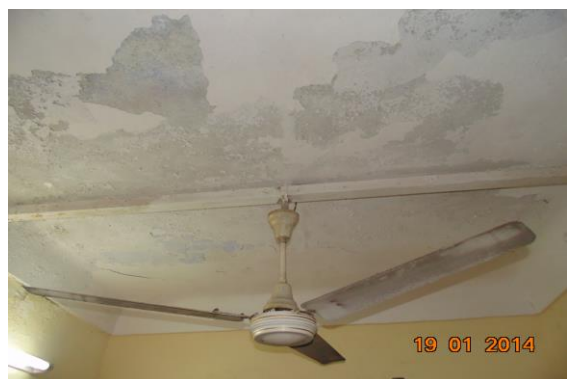
Photo 141

Dampness/Seepage on Wall No. 2 of Reception Room of Police H.Q. Ground Floor, Part A

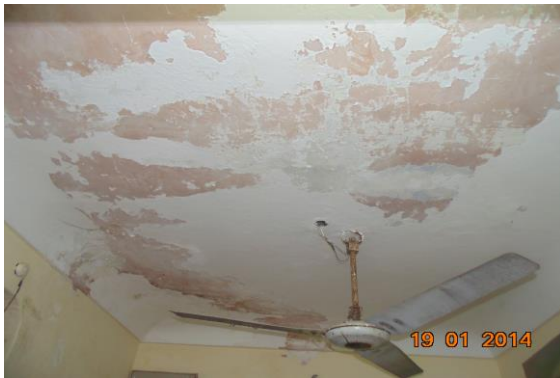
Photo 142

Dampness/Seepage on Roof of Reception Room of Police H.Q. Ground Floor, Part A

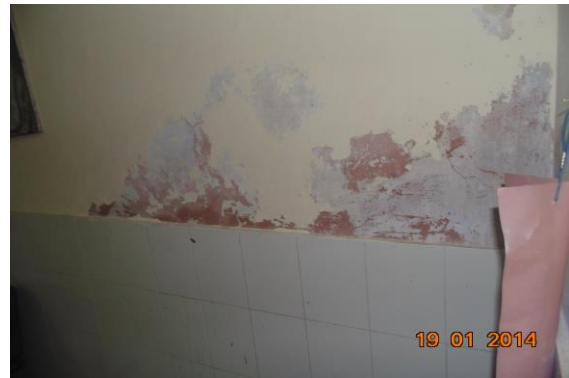
Photo 143

Dampness/Seepage on Roof of Reception Room of Police H.Q. Ground Floor, Part B

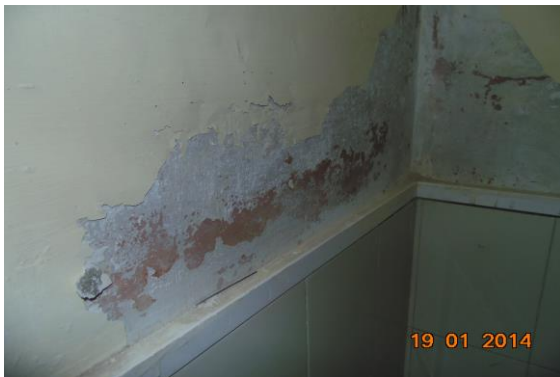
Photo 144

Dampness/Seepage on Wall No. 2 of Reception Room of Police H.Q. Ground Floor, Part B

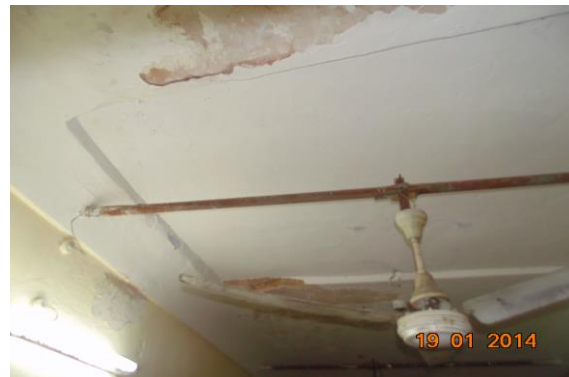
Photo 145

Dampness/Seepage on Wall No. 1 & 3 of Reception Room of Police H.Q. Ground Floor, Part B

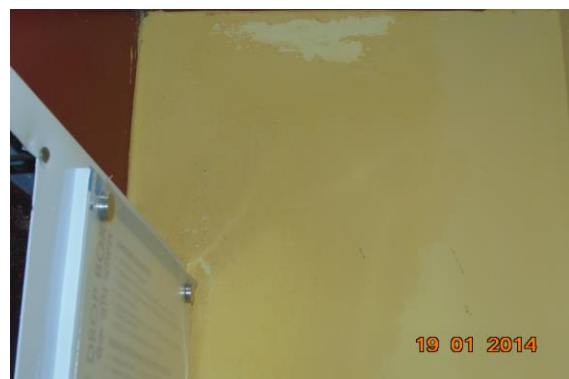
Photo 147

Peeling of Plaster on Wall No. 1 & 3 of Room No. 196 of Police H.Q. Ground Floor, Part A

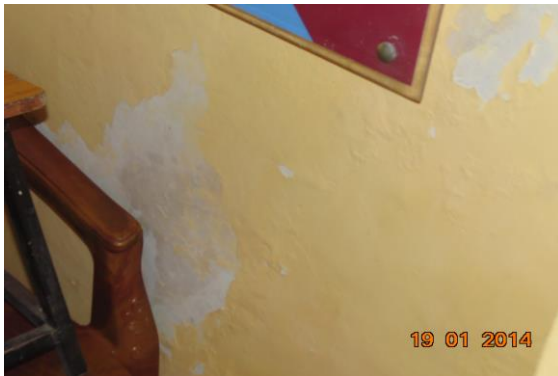
Photo 148

Peeling of Plaster on Wall No. 1 of Axis Bank ATM of Police H.Q. Ground Floor, Part A

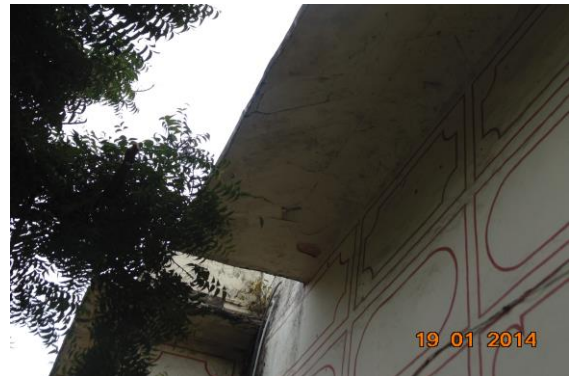
Photo 149

Peeling of Plaster on Wall No. 2 of Axix Bank ATM of Police H.Q. Ground Floor, Part A

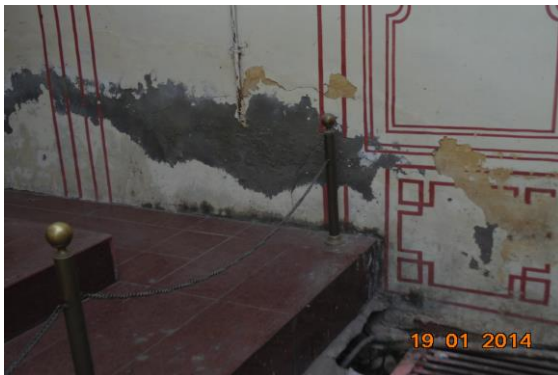
Photo 150

Peeling of Plaster on Shade of Left Side Gate of Police H.Q. Ground Floor, Part C

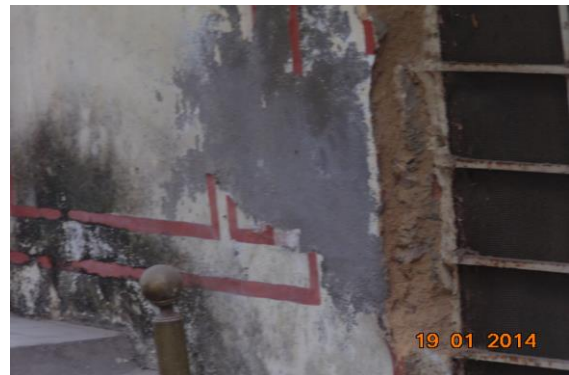
Photo 151

Peeling of Plaster on Left Side Wall of Left Side Gate of Police H.Q. Ground Floor, Part C

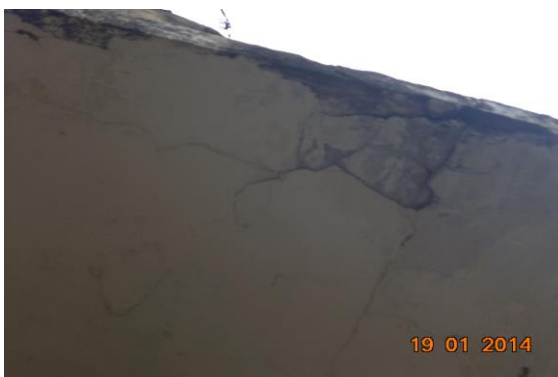
Photo 152

Peeling of Plaster on Left Side Wall of Left Side Gate of Police H.Q. Ground Floor, Part C

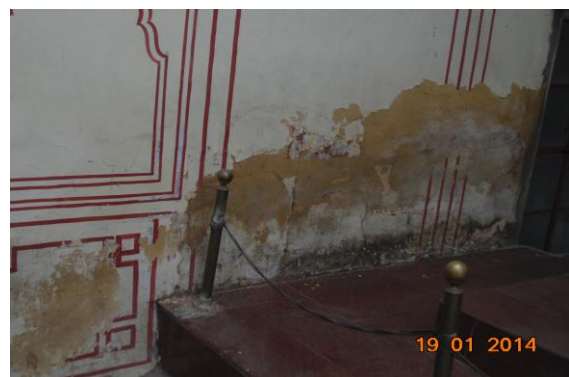
Photo 153

Plaster Crack on Shade of Left Side Gate of Police H.Q. Ground Floor, Part C

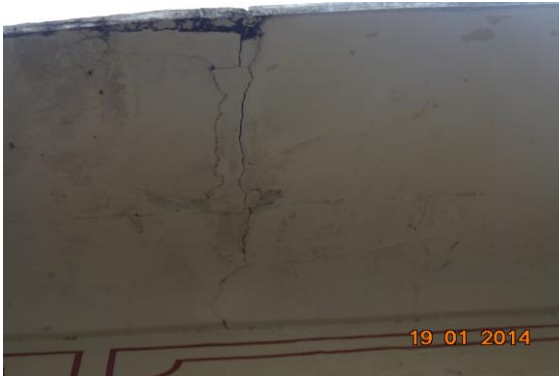
Photo 154

Peeling of Plaster on Right Side Wall of Gate of Police H.Q. Ground Floor, Part C

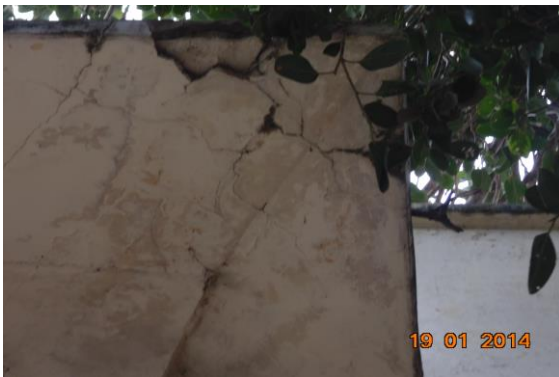
Photo 156

Peeling of Plaster on Right Side Wall of Gate of Police H.Q. Ground Floor, Part C

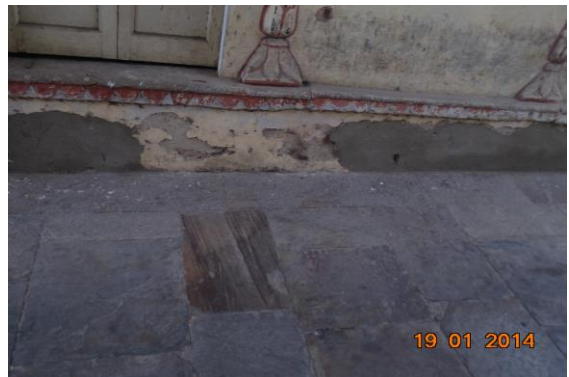
Photo 157

Damaged Portion on Right Side Shade of End Corner of Gate of Police H.Q. Ground Floor, Part C

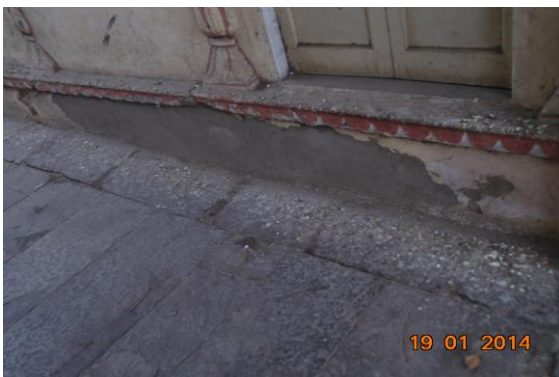
Photo 158

Peeling of Plaster on Wall No. 1 of Face 1 of Gate of Police H.Q. Ground Floor, Part C

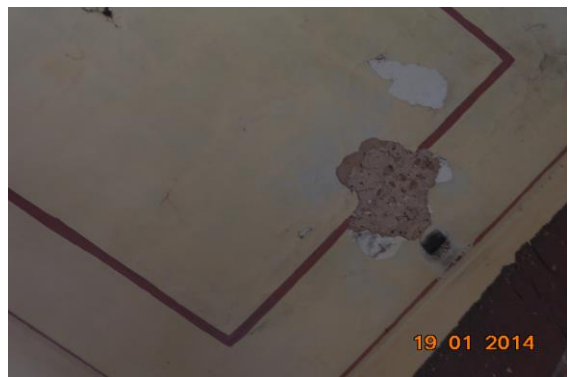
Photo 159

Peeling of Plaster on Wall No. 2 of Face 1 of Gate of Police H.Q. Ground Floor, Part C

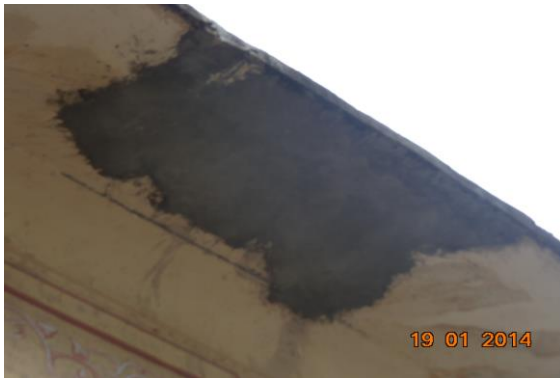
Photo 160

Peeling of Plaster on Roof of Face 2 of Gate of Police H.Q. Ground Floor, Part C

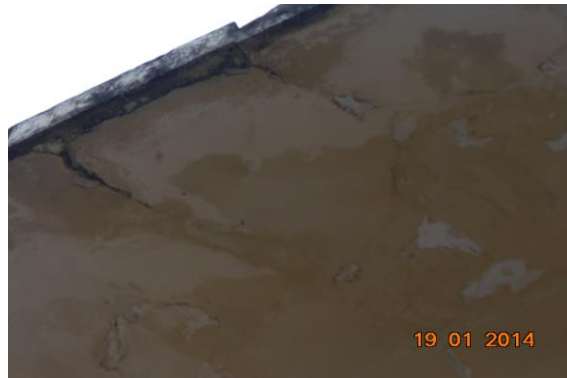
Photo 161

Peeling of Plaster on Shade of Face 3 of Gate of Police H.Q. Ground Floor, Part C

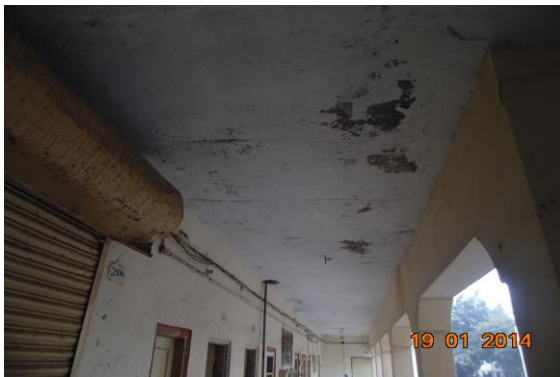
Photo 162

Plaster Crack on Shade of Face 3 of Gate of Police H.Q. Ground Floor, Part C

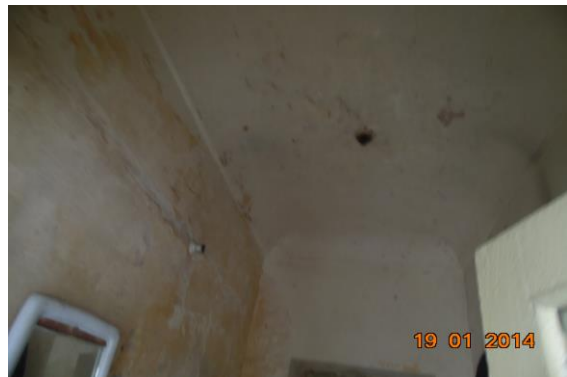
Photo 163

Dampness/Seepage on Shade of Varanda 1 of Police H.Q. Ground Floor, Part C

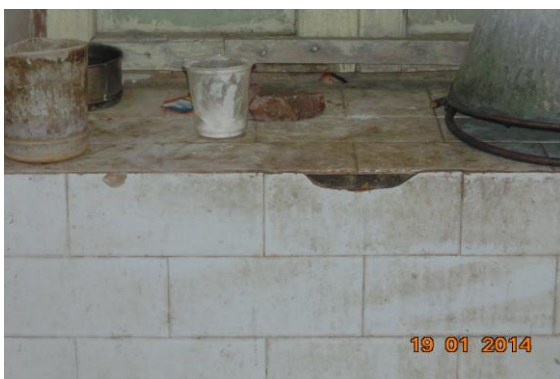
Photo 164

Dampness/Seepage on Wall No. 1, 2 & Roof of Police H.Q. Ground Floor, Part C

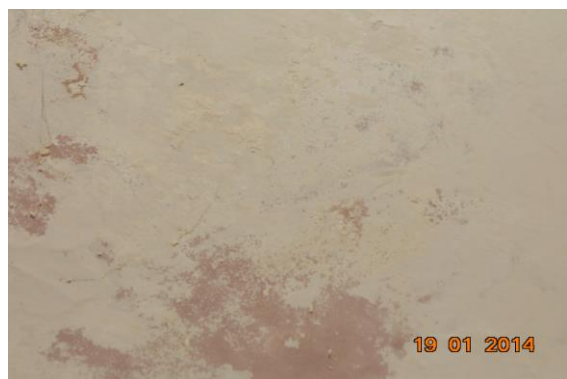
Photo 165

Damaged Portion on Wall No. 4 of Bathroom of Police H.Q. Ground Floor, Part C

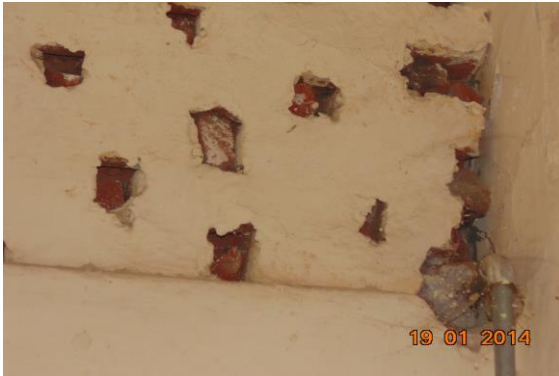
Photo 166

Peeling of Plaster on Roof of Bathroom of Police H.Q. Ground Floor, Part C

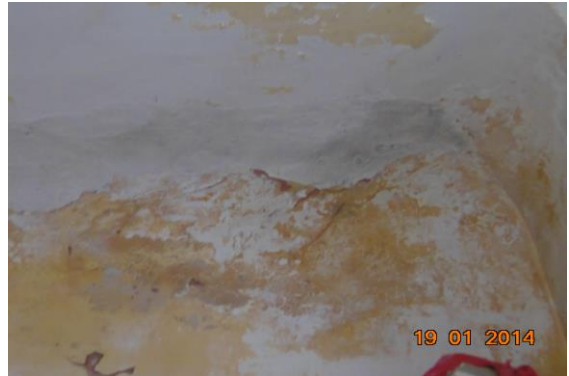
Photo 167

Peeling of Plaster on Wall No. 4 of Room No. 204 of Police H.Q. Ground Floor, Part C

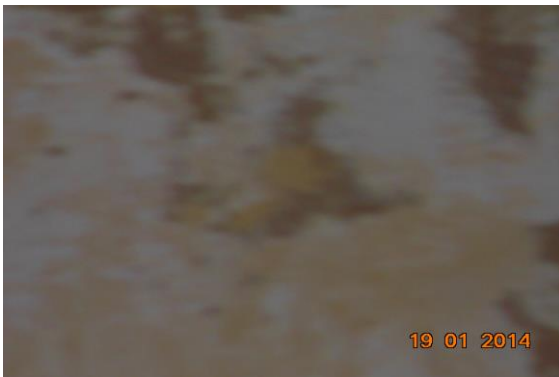
Photo 168

Peeling of Plaster on Wall No. 4 & Roof of Room No. 192 of Police H.Q. Ground Floor, Part C

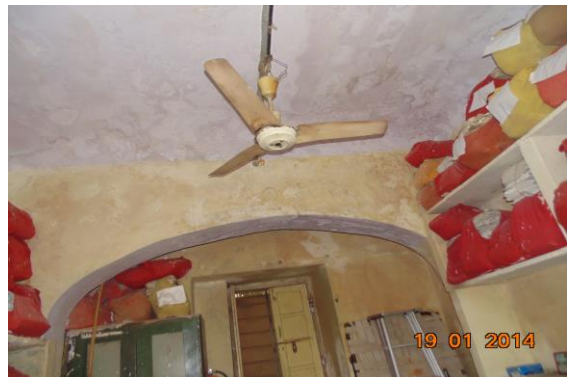
Photo 169

Peeling of Plaster on Wall No. 4 of Room No. 191 of Police H.Q. Ground Floor, Part C

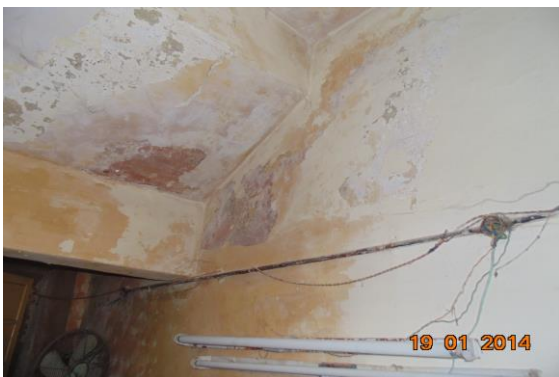
Photo 170

Dampness/Seepage on Wall No. 1 & Roof of Room No. 189 of Police H.Q. Ground Floor, Part C

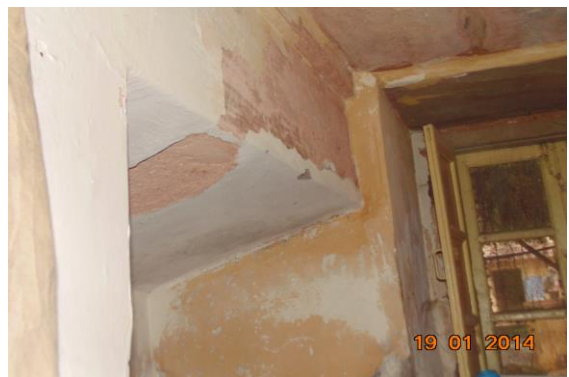
Photo 171

Dampness/Seepage on Wall No. 2 & Roof of Room No. 188 of Police H.Q. Ground Floor, Part C

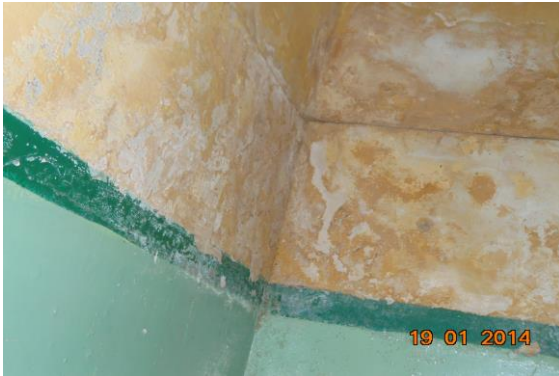
Photo 172

Peeling of Plaster on Wall No. 1 of Room No. 188 of Police H.Q. Ground Floor, Part C

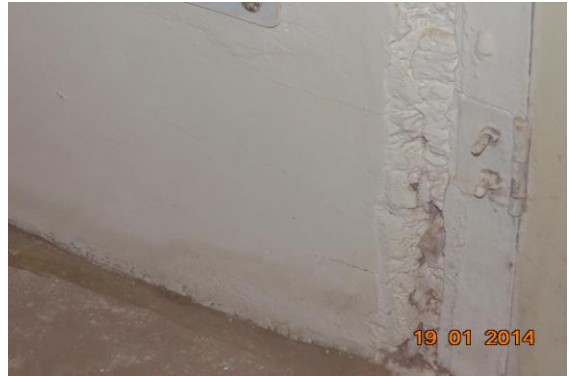
Photo 173

Dampness/Seepage on Wall No. 1 & 4 of Stair 1 of Police H.Q. Ground Floor, Part C

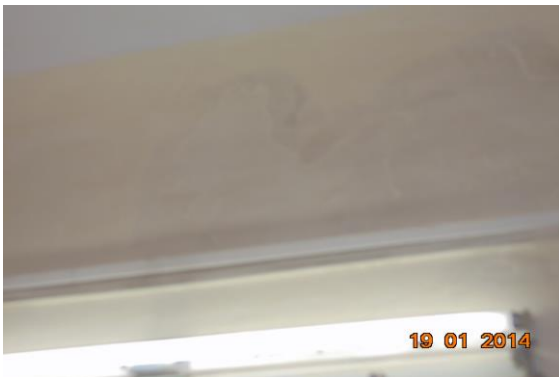
Photo 174

Peeling of Plaster on Wall No. 2 of Kitchen of Police H.Q. Ground Floor, Part B

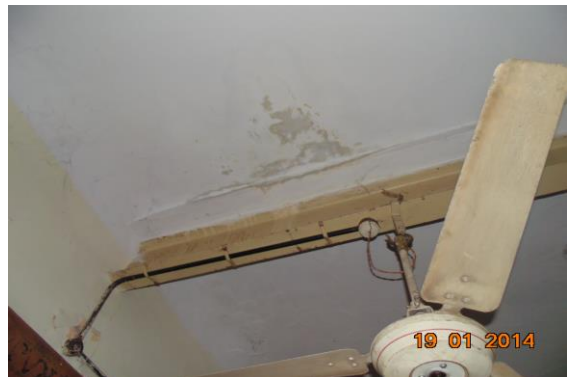
Photo 175

Peeling of Plaster on Wall No. 2 of Room No. 107 of Police H.Q. Ground Floor, Part B

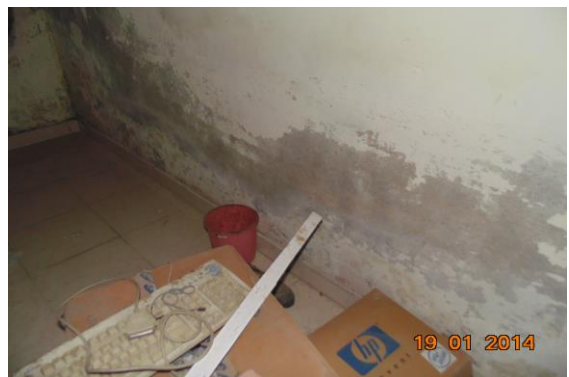
Photo 177

Peeling of Plaster on Wall No. 2 of Room No. 106 of Police H.Q. Ground Floor, Part A

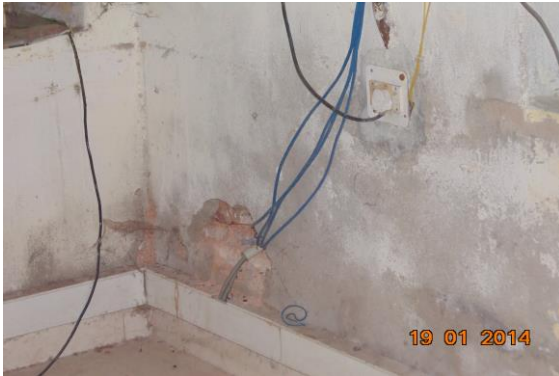
Photo 179

Peeling of Plaster on Wall No. 2 & 4 of Room No. 106 of Police H.Q. Ground Floor, Part A

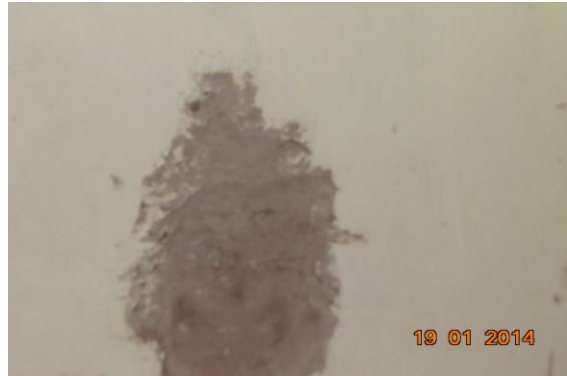
Photo 180

Peeling of Plaster on Wall No. 1 of Room No. 106 of Police H.Q. Ground Floor, Part A

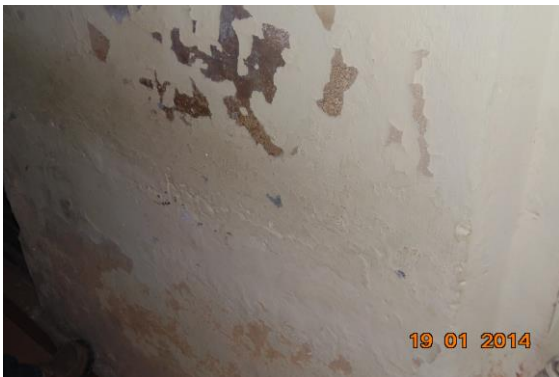
Photo 181

Peeling of Plaster on Wall No. 2 of Room No. 193 of Police H.Q. Ground Floor, Part A

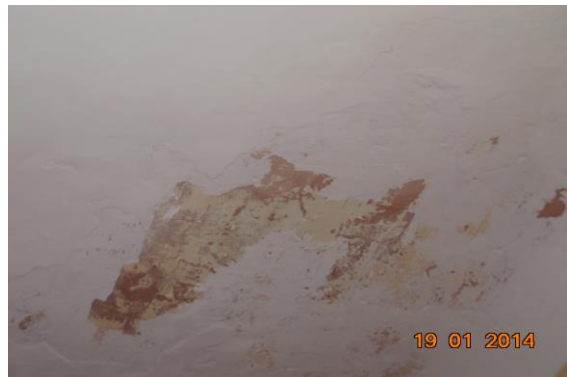
Photo 182

Peeling of Plaster on Roof of Room No. 193 of Police H.Q. Ground Floor, Part C

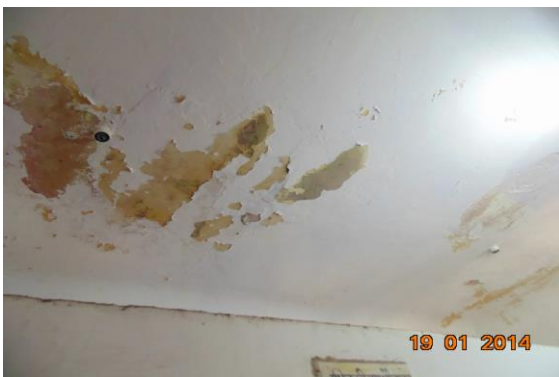
Photo 183

Dampness/Seepage on Roof of Toilet No. 1 of Police H.Q. First Floor, Part D

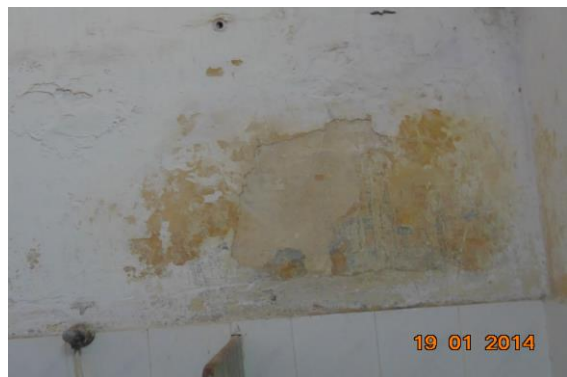
Photo 184

Dampness/Seepage on Wall No. 4 of Passage of Police H.Q. First Floor, Part D

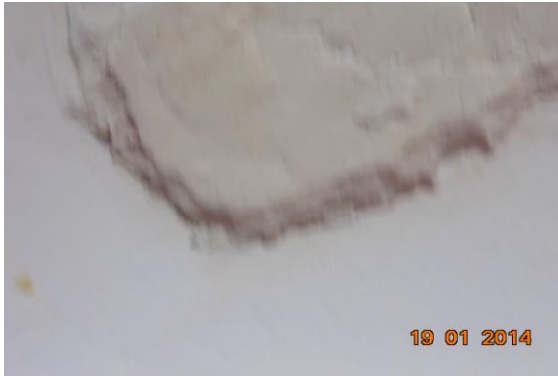
Photo 185

Peeling of Plaster on Roof of Toilet No. 2 of Police H.Q. First Floor, Part D

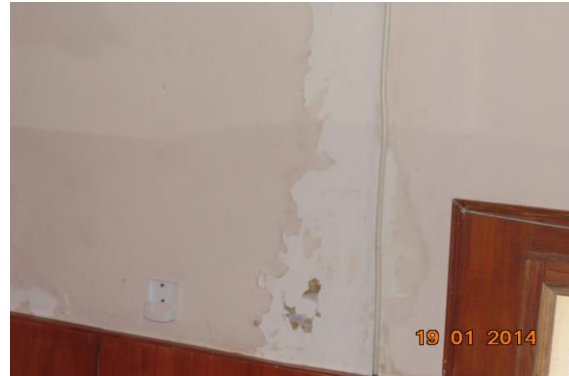
Photo 186

Peeling of Plaster on Wall No. 4 of Room No. 389 of Police H.Q. First Floor, Part D

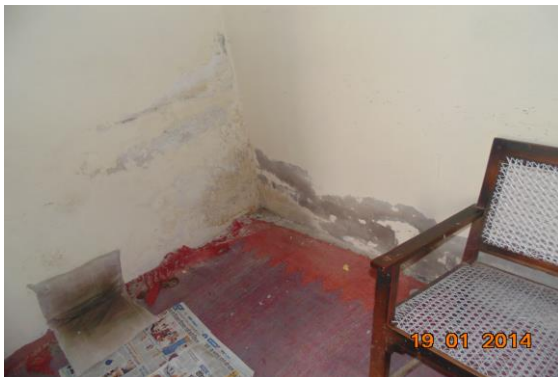
Photo 187

Peeling of Plaster on Wall No. 1 & 4 of Room No. 391 of Police H.Q. First Floor, Part D

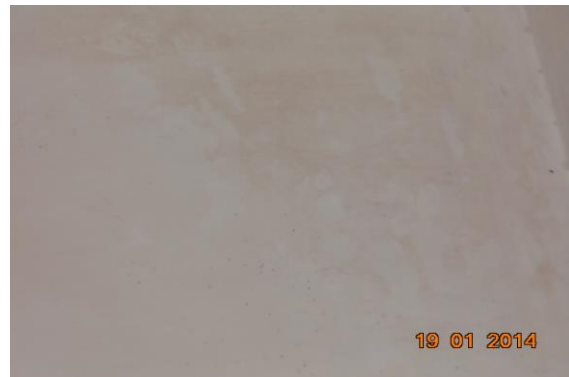
Photo 188

Dampness/Seepage on Wall No. 4 of Room No. 393 of Police H.Q. First Floor, Part D

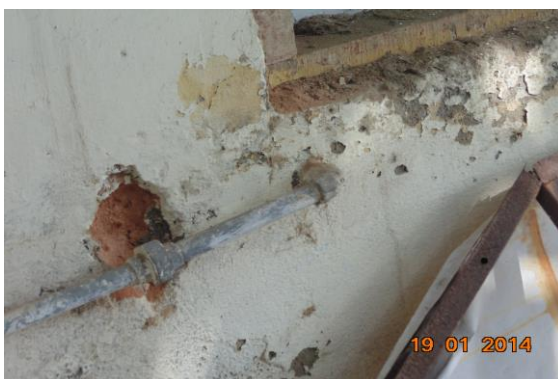
Photo 189

Peeling of Plaster on Wall No. 2 of Towards Gate of Police H.Q. First Floor, Part C

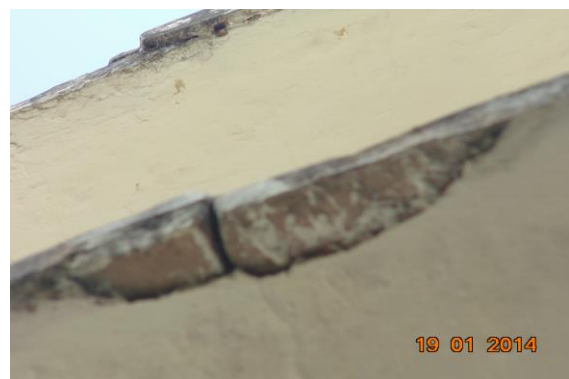
Photo 190

Peeling of Plaster on Shade of Towards Gate of Police H.Q. First Floor, Part C

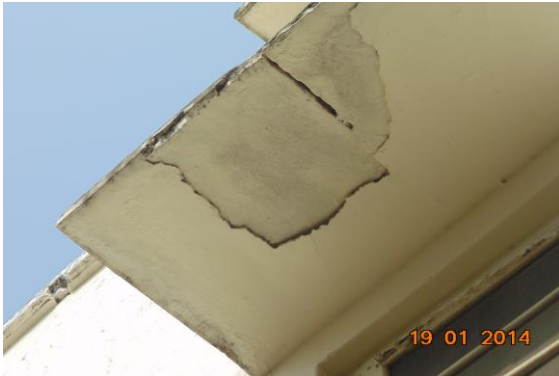
Photo 191

Peeling of Plaster on Shade of Towards Gate of Police H.Q. First Floor, Part C

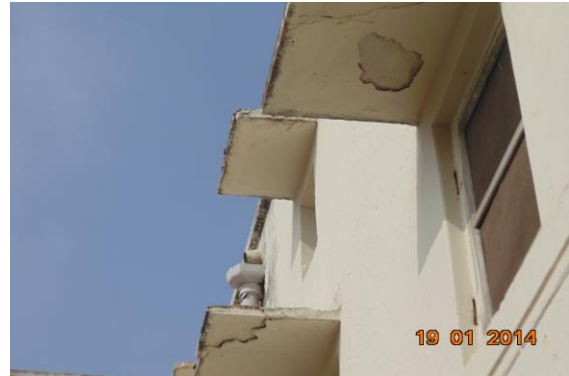
Photo 192

Peeling of Plaster on Shade of Towards Gate of Police H.Q. First Floor, Part C

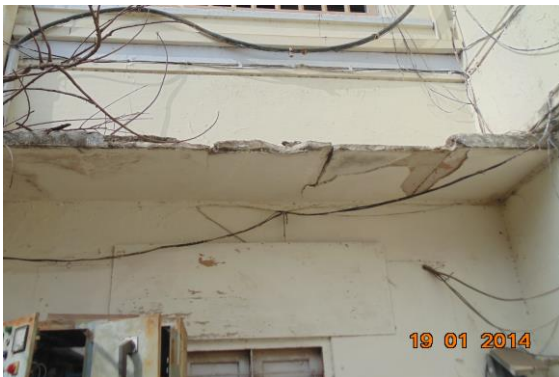
Photo 193

Peeling of Plaster on Wall No. 2 of Outer Wall of Police H.Q. Ground Floor, Part B

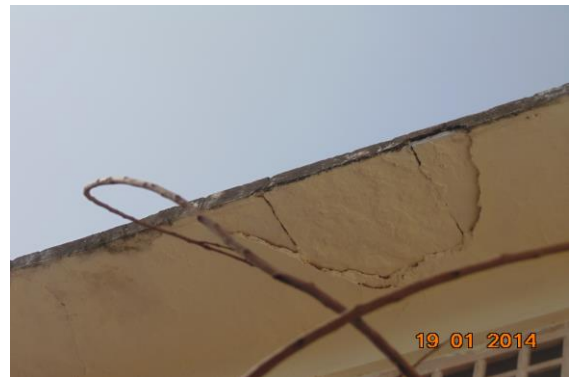
Photo 194

Peeling of Plaster on Wall No. 4 & Shade of Outer Wall of Police H.Q. Ground Floor, Part B

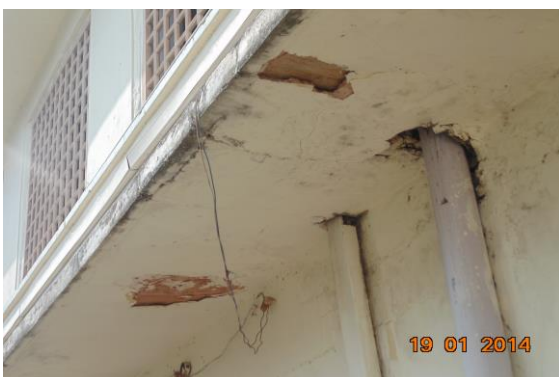
Photo 195

Peeling of Plaster on Wall No. 4 & Shade of Outer Wall of Police H.Q. First Floor, Part C

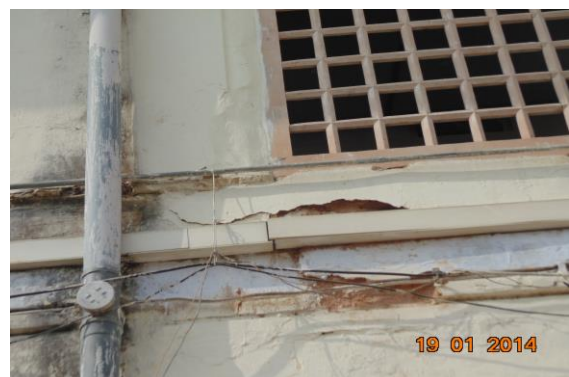
Photo 196

Peeling of Plaster on Wall No. 4 & Shade of Outer Wall of Police H.Q. Ground Floor, Part B

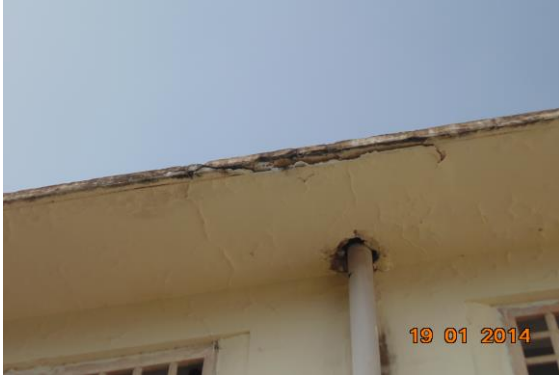
Photo 197

Peeling of Plaster on Wall No. 4 of Outer Wall of Police H.Q. First Floor, Part C

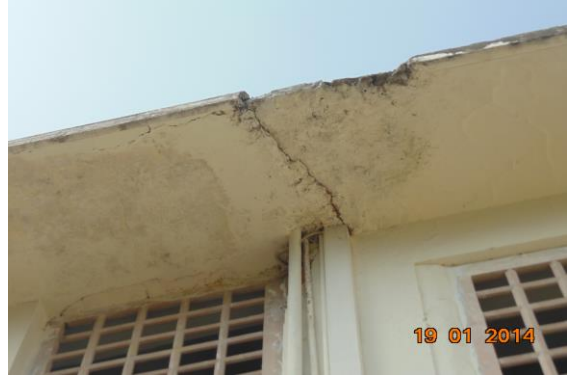
Photo 198

Peeling of Plaster on Shade of Outer Wall of Police H.Q. First Floor, Part C

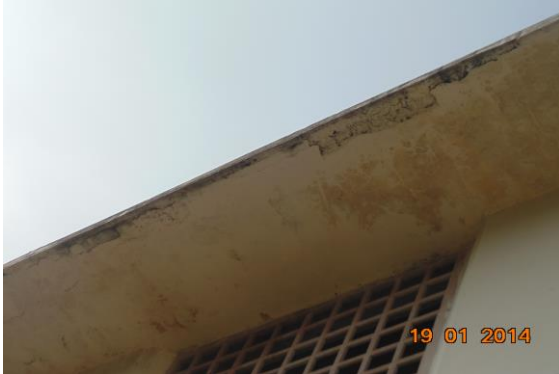
Photo 199

Damaged Portion on Wall No. 4 & Shade of Outer Wall of Police H.Q. First Floor, Part C

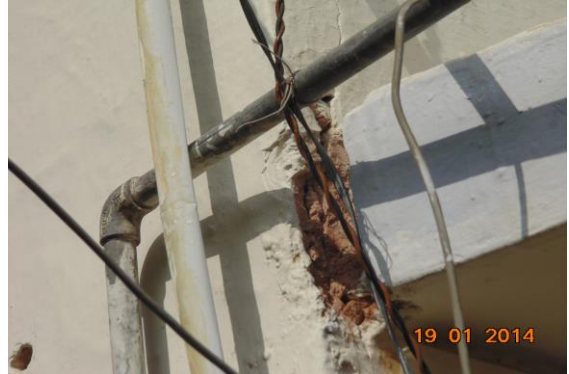
Photo 200

Peeling of Plaster on Wall No. 4 & Shade of Outer Wall of Police H.Q. First Floor, Part C

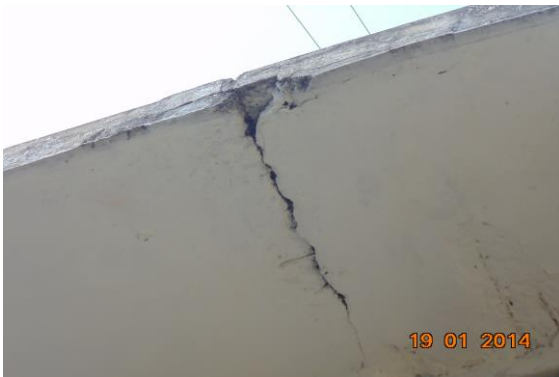
Photo 201

Peeling of Plaster on Wall No. 4 of Outer Wall of Police H.Q. Ground Floor, Part B

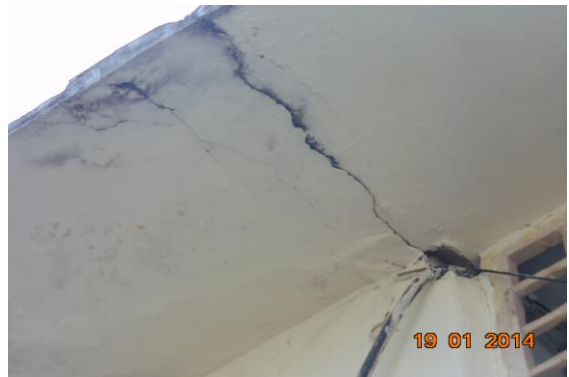
Photo 202

Peeling of Plaster on Shade of Outer Wall of Police H.Q. First Floor, Part C

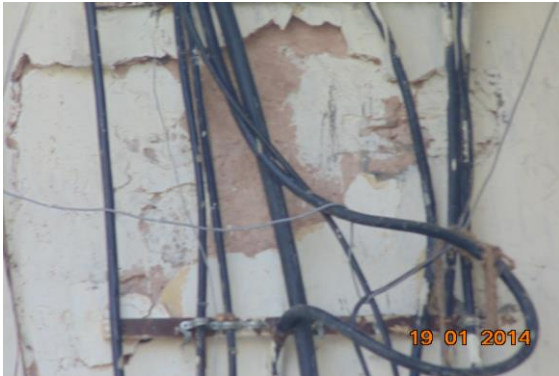
Photo 203

Peeling of Plaster on shade Joint of Outer Wall of Police H.Q. First Floor, Part C

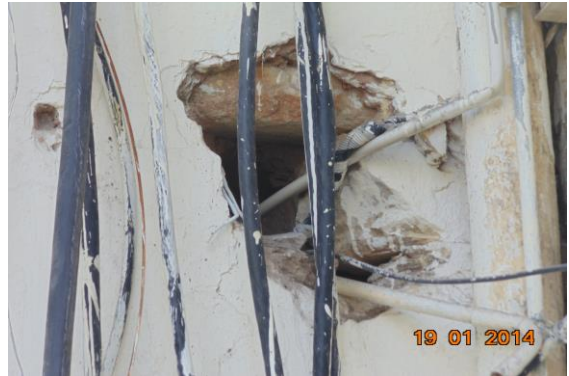
Photo 204

Peeling of Plaster on Wall No. 1 of Outer Wall of Police H.Q. First Floor, Part C

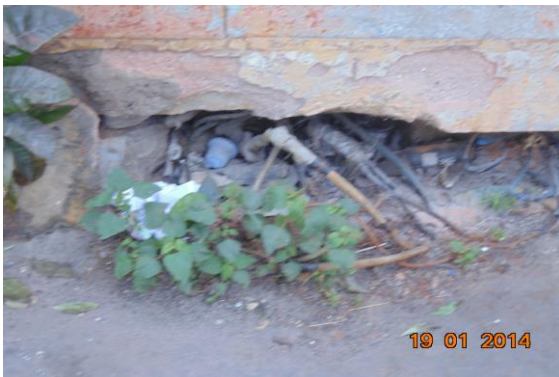
Photo 205

Peeling of Plaster on Wall No. 1 of Outer Wall of Police H.Q. Ground Floor, Part B

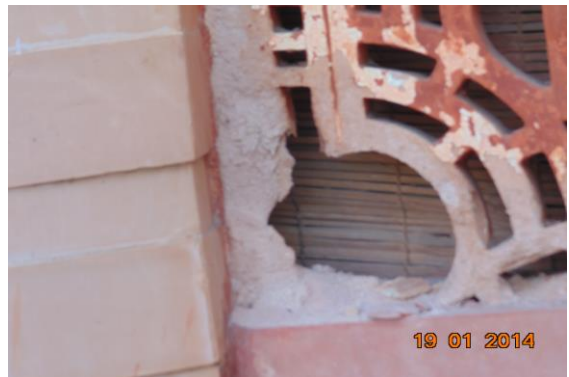
Photo 206

Damaged Portion on Wall No. 1 of Outer Wall of Police H.Q. Ground Floor, Part B

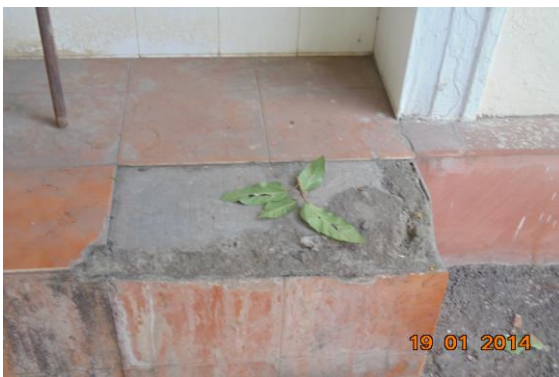
Photo 207

Damaged Portion on Wall No. 1 of Outer Wall, Window RCC Mess of Police H.Q. Ground Floor, Part B

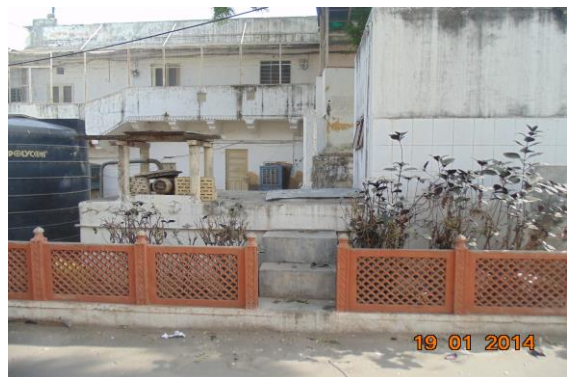
Photo 208

Damaged Portion on Wall No. 1 of Outer Wall of Police H.Q. Ground Floor, Part B

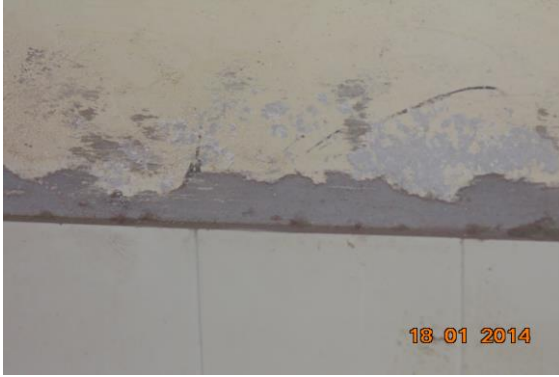
Photo 209

Peeling of Plaster on Wall No. 4 of Hall No. 1 of Police H.Q. Ground Floor, Part B
