Pre Building Condition Survey Report

Name and Address of Structure :	Choti Chopar to Badi Chopar (UP Line)
---------------------------------	---------------------------------------

Name of the Project	Contract JMRC-UG1B “Design and Construction of Tunnel between Chandpole and Badi Chouper and reverse line by Shield TBM, Underground Metro Stations at Choti Chouper and Badi Chouper by Cut and Cover Methods on East West Corridor of Jaipur Metro Rail Corporation Limited .”	
Owner :

Shoping Complex - Shop No. 169-188
Tripolia Bazar
Jaipur
Unique ID: CC BC UP 0001

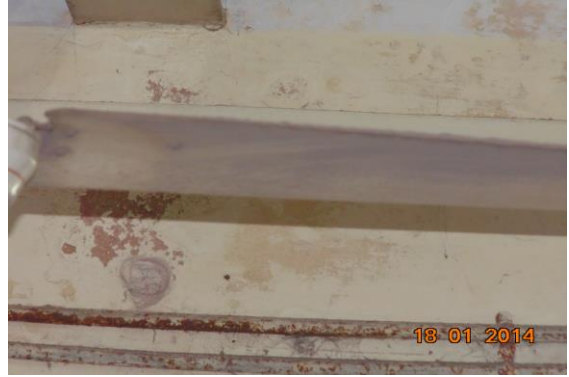
Photo 210

Peeling of Plaster on Wall No. 4 of Hall No. 2 of Police H.Q. Ground Floor, Part B

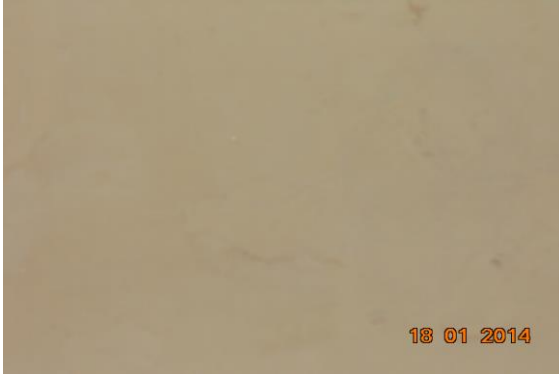
Photo 211

Peeling of Plaster on Wall No. 4 of Hall No. 3 of Police H.Q. Ground Floor, Part B

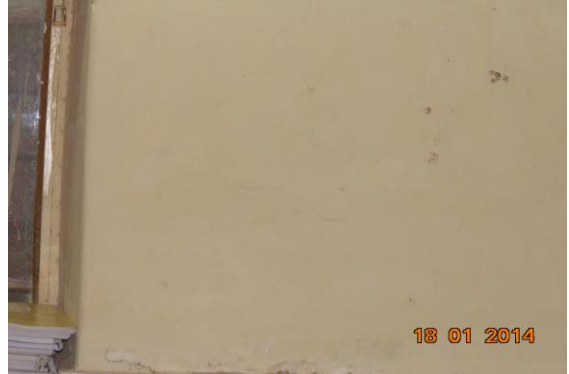
Photo 212

Peeling of Plaster on Wall No. 2 of Hall No. 3 of Police H.Q. Ground Floor, Part B

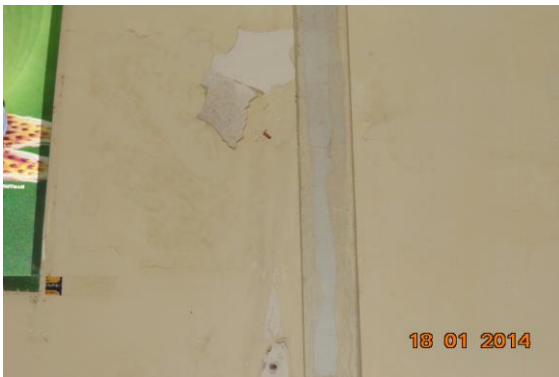
Photo 213

Peeling of Plaster on Wall No. 2 of Hall No. 3 of Police H.Q. Ground Floor, Part B

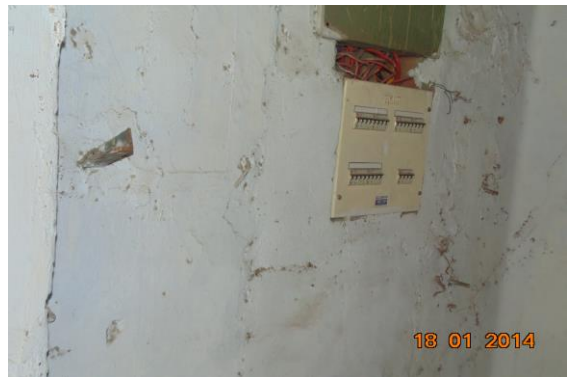
Photo 214

Peeling of Plaster on Wall No. 1 of Lobby of Police H.Q. Ground Floor, Part B

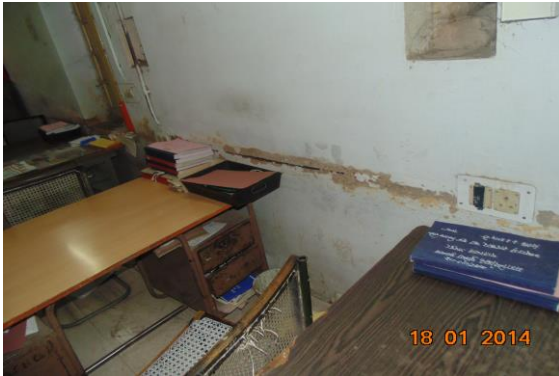
Photo 215

Peeling of Plaster on Wall No. 2 of Room No. 112, Part B of Police H.Q. Ground Floor, Part B

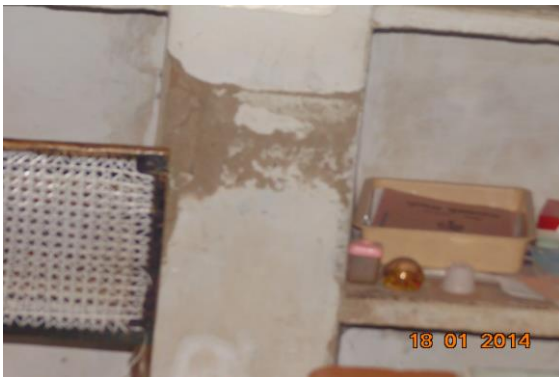
Photo 217

Peeling of Plaster on Wall No. 4 of Room No. 112, Part C of Police H.Q. Ground Floor, Part B

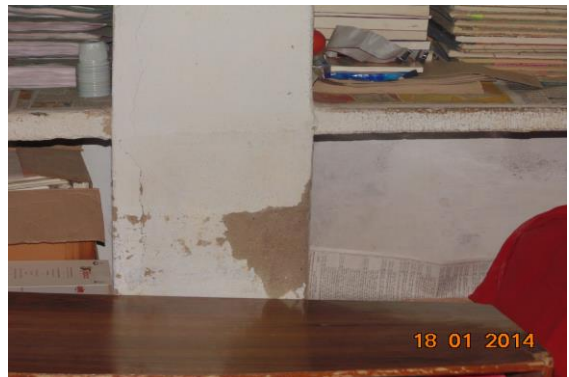
Photo 218

Peeling of Plaster on Wall No. 4 of Room No. 112, Part E of Police H.Q. Ground Floor, Part B

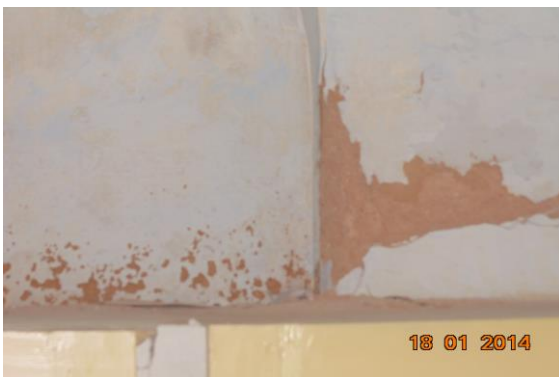
Photo 219

Peeling of Plaster on Wall No. 4 of Room No. 112, Part D of Police H.Q. Ground Floor, Part B

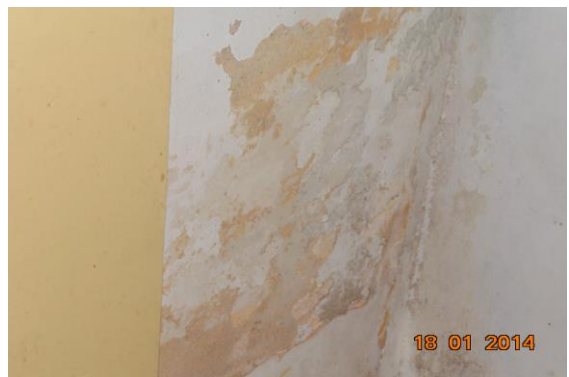
Photo 220

Peeling of Plaster on Wall No. 4 of Room No. 113, Part B of Police H.Q. Ground Floor, Part B

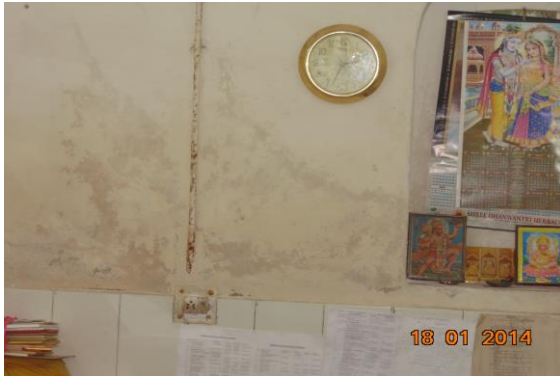
Photo 221

Peeling of Plaster on Wall No. 4 of Room No. 113, Part B of Police H.Q. Ground Floor, Part B

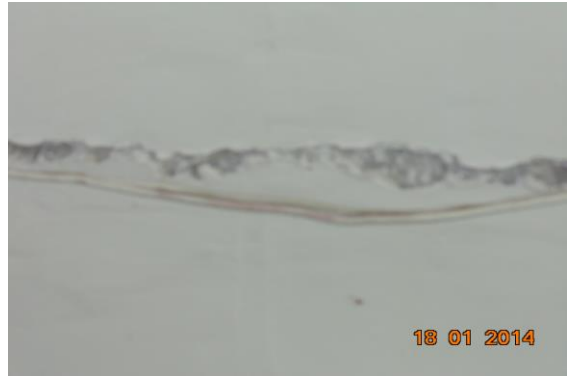
Photo 222

Peeling of Plaster on Roof of Police H.Q. Ground Floor, Part B

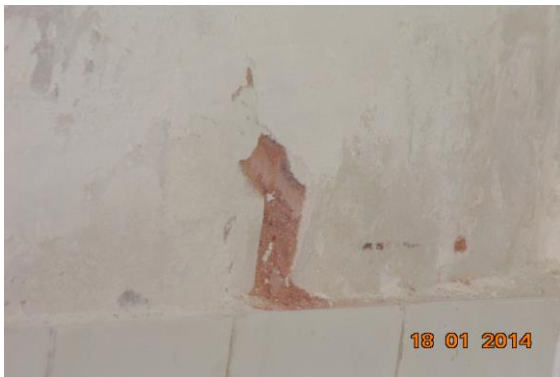
Photo 223

Peeling of Plaster on Wall No. 1 of Room No. 113, Part B of Police H.Q. Ground Floor, Part B

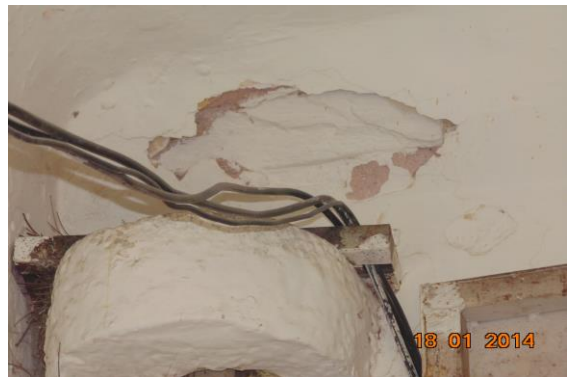
Photo 224

Peeling of Plaster on Wall No. 4 of Gate 2 of Police H.Q. Ground Floor, Part B

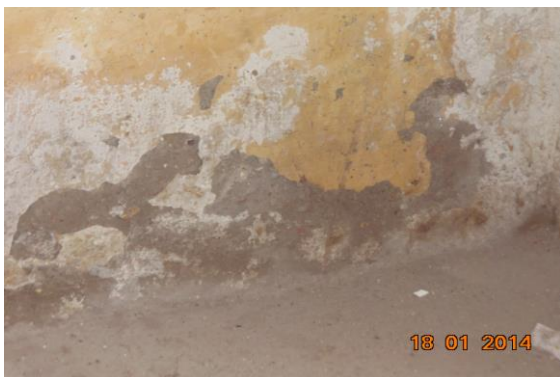
Photo 225

Peeling of Plaster on Wall No. 2 of Gate 3 of Police H.Q. Ground Floor, Part B

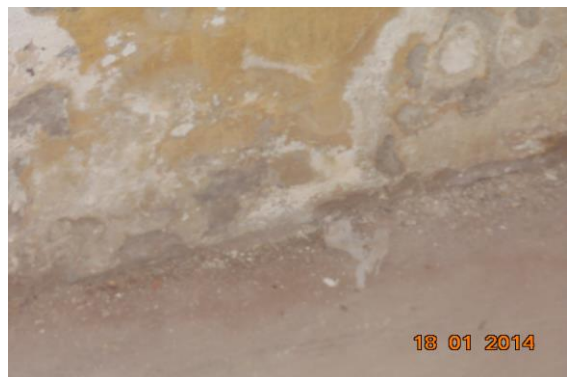
Photo 226

Peeling of Plaster on Wall No. 1 of Gate 4 of Police H.Q. Ground Floor, Part B

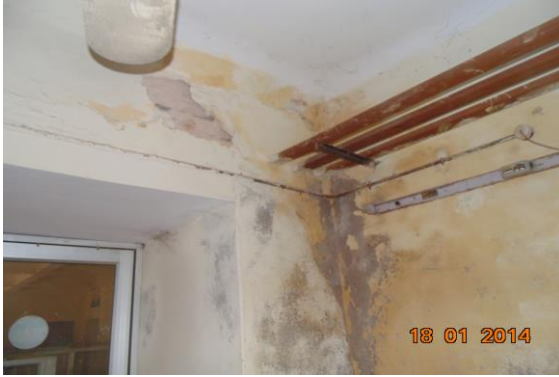
Photo 227
Peeling of Plaster on Wall No. 2 & 4 of Room No. 116 of Police
H.Q. Ground Floor, Part B

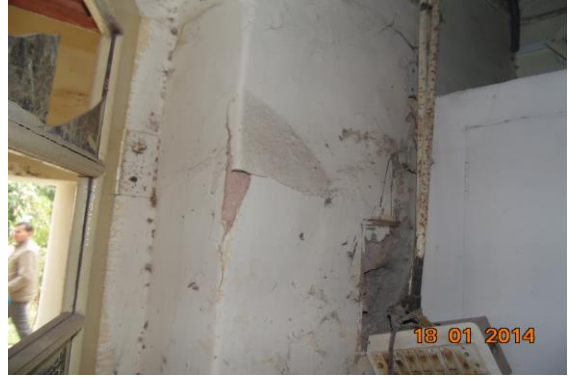
Photo 228
Peeling of Plaster on Wall No. 3 of . Room No. 116 of Police
H.Q. Ground Floor, Part B

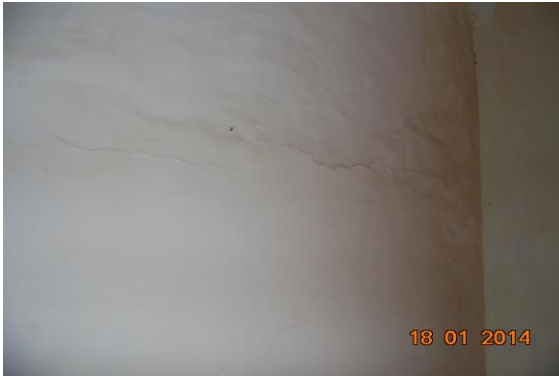
Photo 229
Plaster Crack on Wall No. 3 of Hall No. 4 of Police H.Q. Ground Floor,
Part B

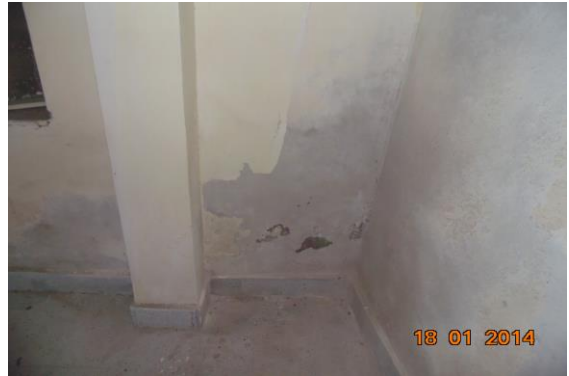
Photo 230
Peeling of Plaster on Wall No. 2 of Hall No. 4 of Police H.Q. Ground
Floor, Part B

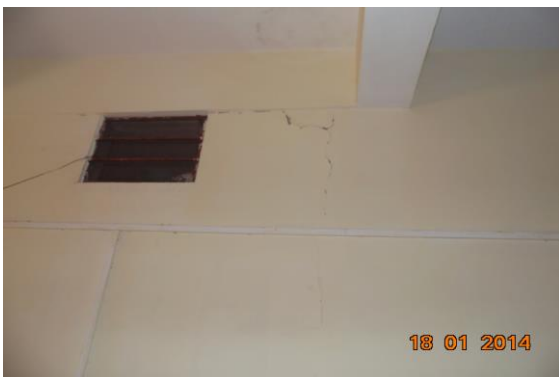
Photo 231
Plaster Crack on Wall No. 4 of Hall No. 4 of Police H.Q. Ground Floor,
Part B

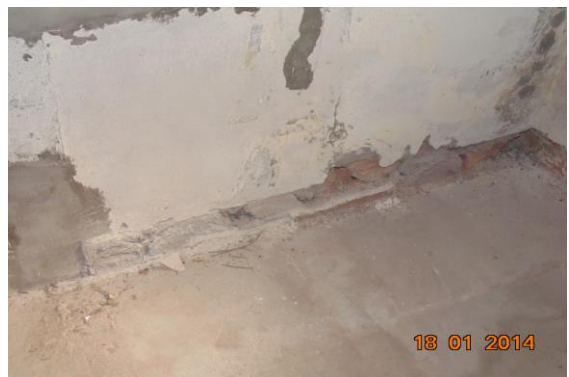
Photo 232
Peeling of Plaster on Wall No. 3 of Hall No. 4 of Police H.Q. Ground
Floor, Part B

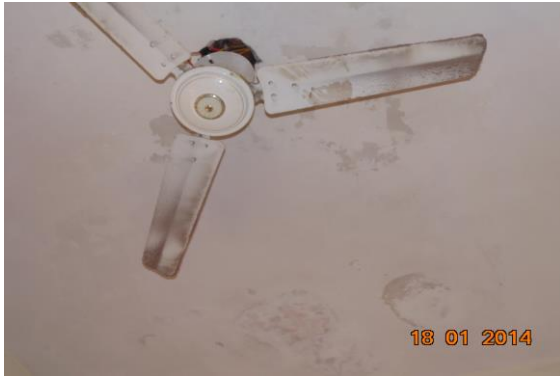
Photo 233

Dampness/Seepage on Roof of Hall No. 4 of Police H.Q. Ground Floor, Part B

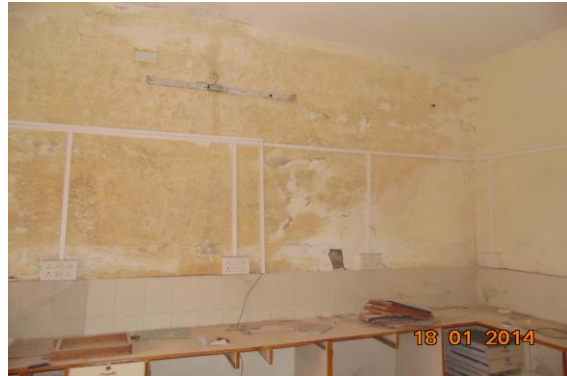
Photo 234

Peeling of Plaster on Wall No. 4 of Hall No. 4 of Police H.Q. Ground Floor, Part A

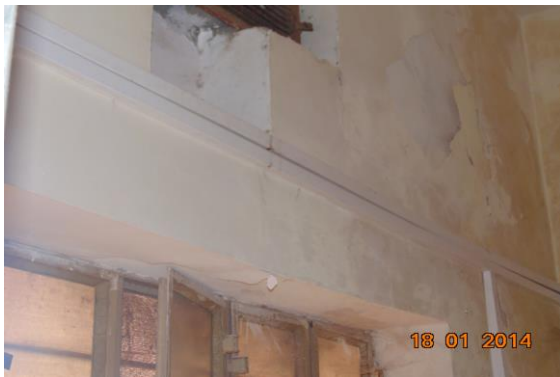
Photo 235

Peeling of Plaster on Wall No. 1 of Hall No. 4 of Police H.Q. Ground Floor, Part A

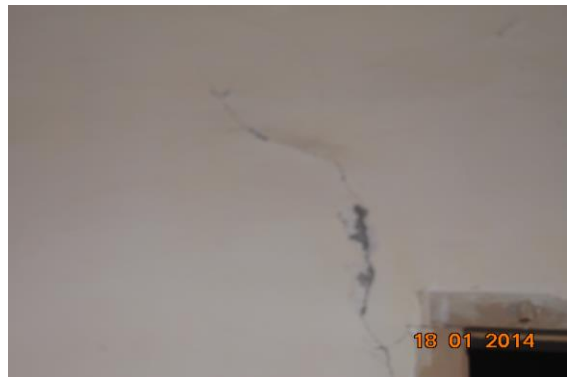
Photo 236

Peeling of Plaster on Wall No. 2 of Hall No. 4 of Police H.Q. Ground Floor, Part A

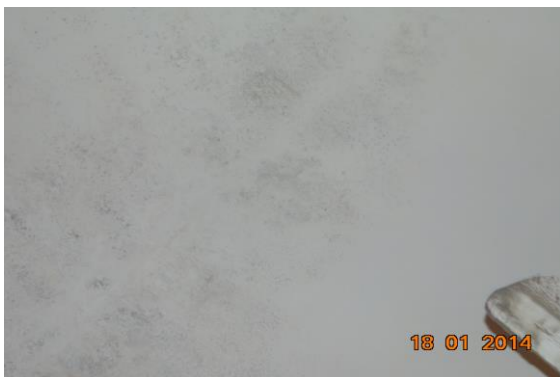
Photo 237

Dampness/Seepage on Roof of Hall No. 4 of Police H.Q. Ground Floor, Part A

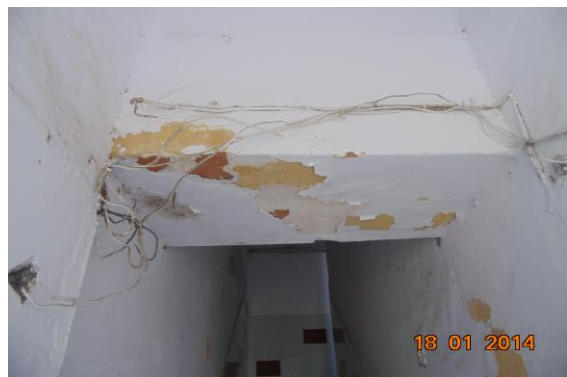
Photo 238

Peeling of Plaster on Roof of Stair 3 of Police H.Q. Ground Floor, Part B

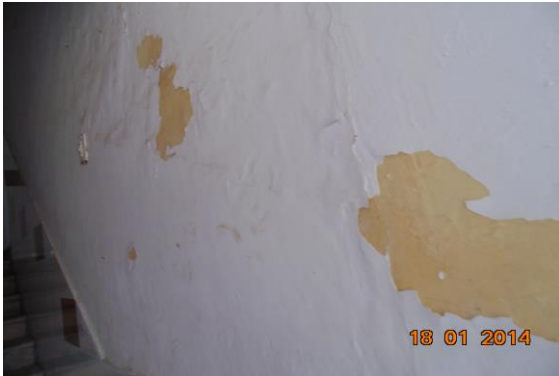
Photo 239

Peeling of Plaster on Wall No. 2 of Stair 3 of Police H.Q. Ground Floor, Part B

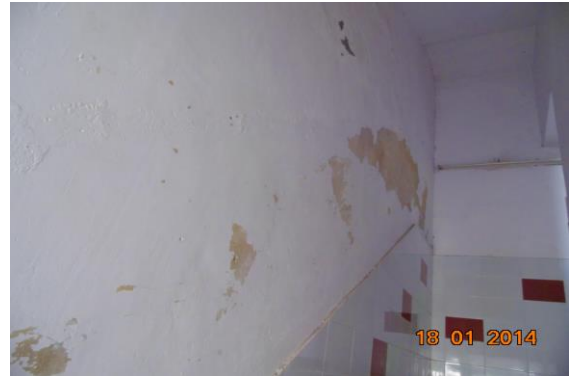
Photo 240

Peeling of Plaster on Wall No. 1 of Stair 3 of Police H.Q. Ground Floor, Part B

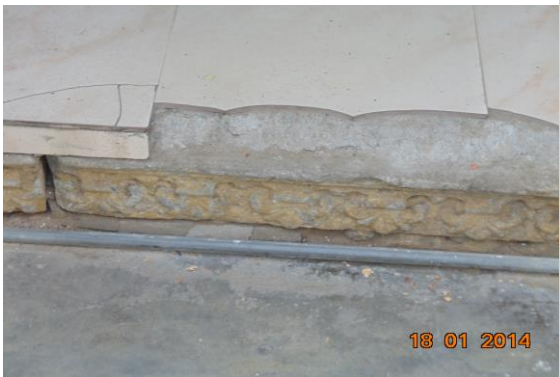
Photo 241

Damaged Portion on Floor of Room No.118 of Police H.Q. Ground Floor, Part B

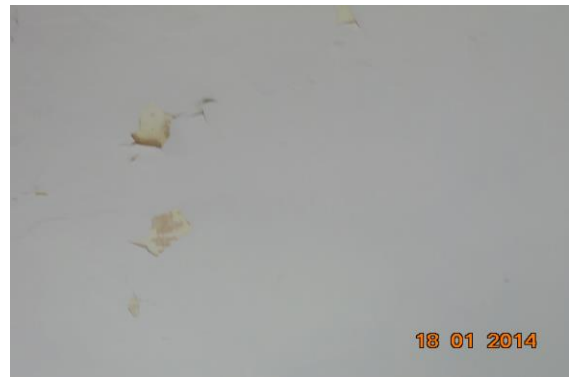
Photo 242

Peeling of Plaster on Roof of Room No.118 of Police H.Q. Ground Floor, Part B

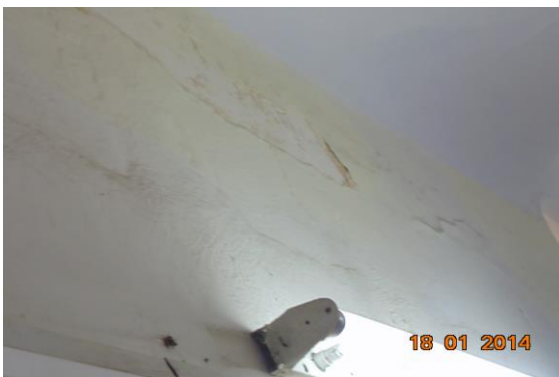
Photo 243

Peeling of Plaster on Wall No. 3 of Room No.118 of Police H.Q. Ground Floor, Part B

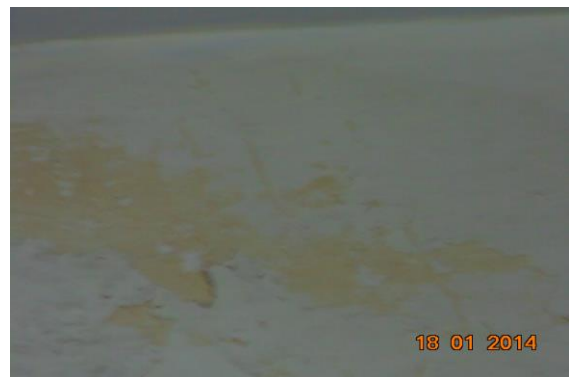
Photo 244

Peeling of Plaster on Wall No. 1 of Room No.118 of Police H.Q. Ground Floor, Part B

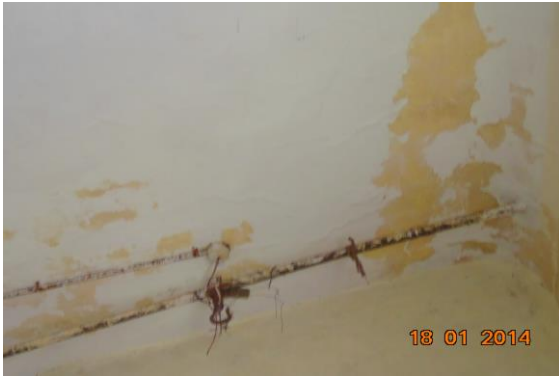
Photo 245

Peeling of Plaster on Roof of Room No.119 of Police H.Q.Ground Floor, Part B

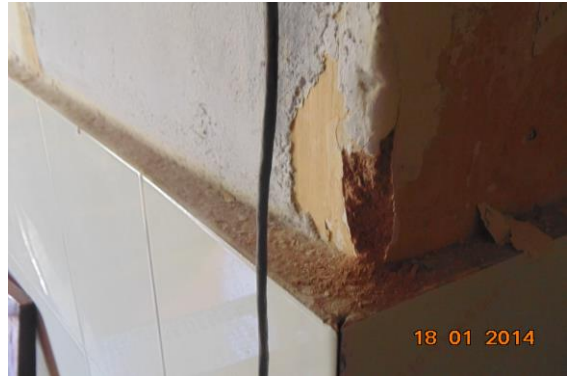
Photo 246

Peeling of Plaster on Wall No. 1 of Room No.119 of Police H.Q.Ground Floor, Part B

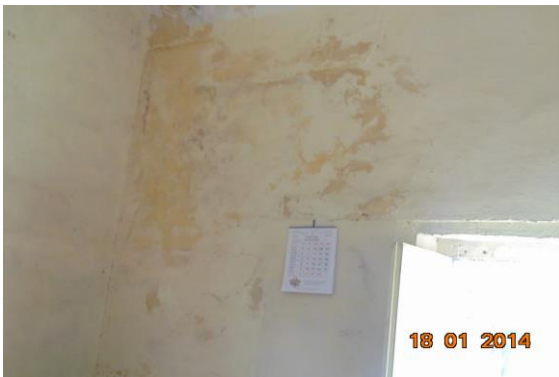
Photo 247

Peeling of Plaster on Wall No. 3 of Room No.119 of Police H.Q.Ground Floor, Part B

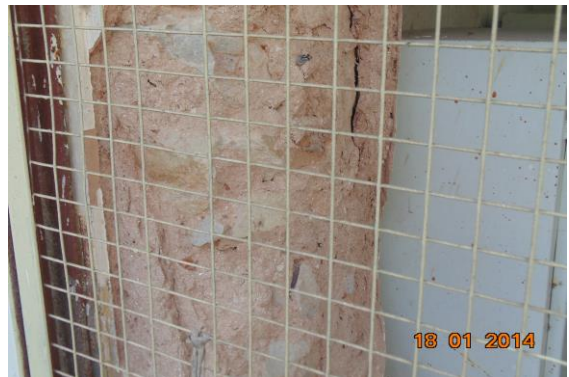
Photo 248

Peeling of Plaster on Wall No. 3 of Room No.119 of Police H.Q.Ground Floor, Part B

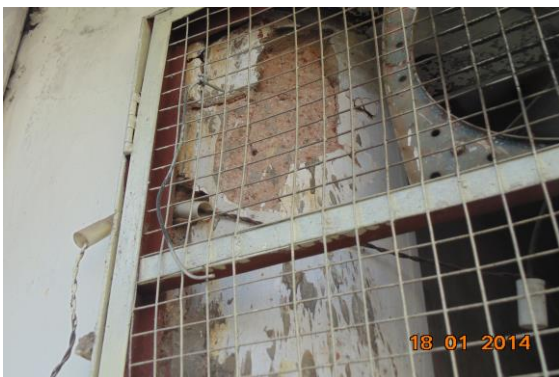
Photo 249

Peeling of Plaster on Wall No. 3 of Room No.119 of Police H.Q.Ground Floor, Part B

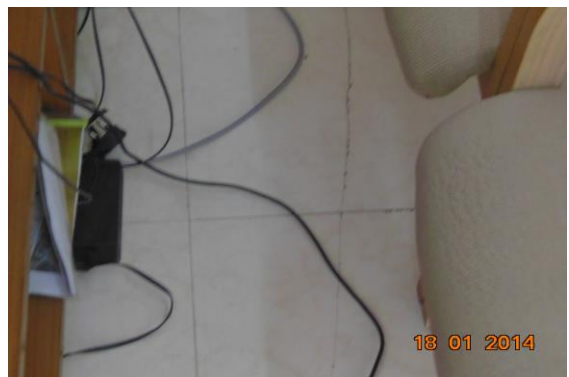
Photo 250

Damaged Portion on Floor of Room No.122 of Police H.Q.Ground Floor, Part B

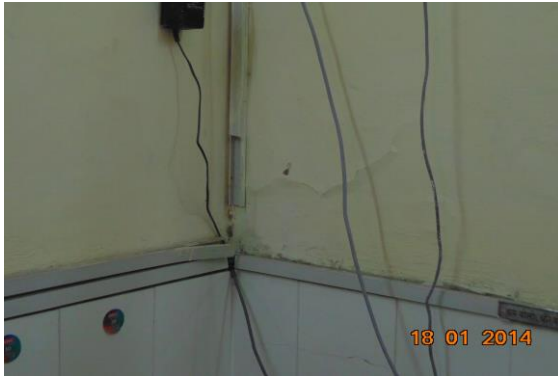
Photo 251

Peeling of Plaster on Wall No. 4 of Room No.123 of Police H.Q.Ground Floor, Part B

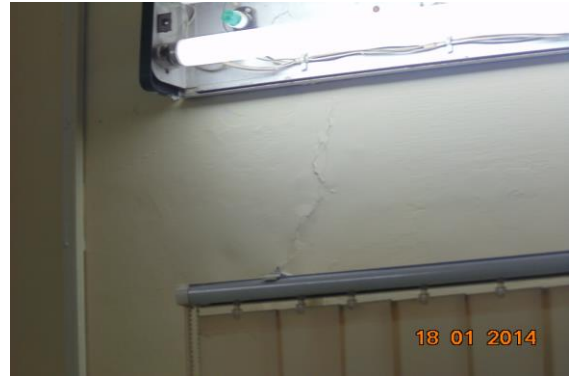
Photo 252

Plaster Crack on Wall No. 4 of Room No.124 of Police H.Q.Ground Floor, Part B

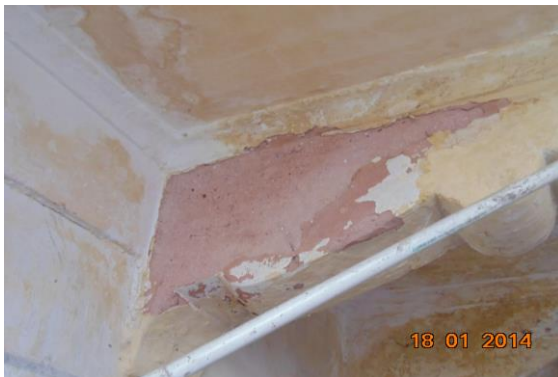
Photo 253

Peeling of Plaster on Wall No. 1 & Shade of Outer Wall of Police H.Q.Ground Floor, Part A

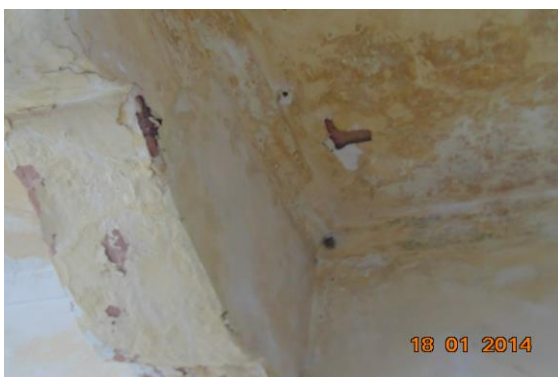
Photo 255

Dampness/Seepage on Wall No. 1 & Shade of Outer Wall of Police H.Q.Ground Floor, Part A

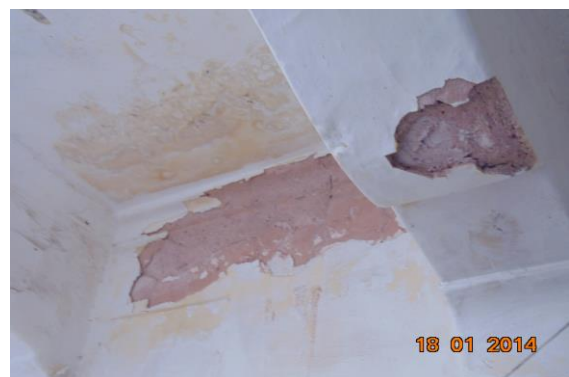
Photo 256

Peeling of Plaster on Wall No. 1 & Shade of Outer Wall of Police H.Q.Ground Floor, Part A

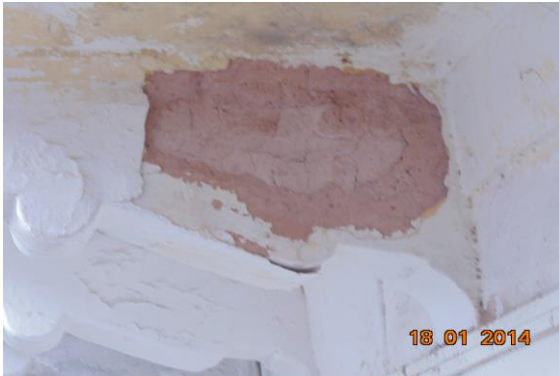
Photo 257

Peeling of Plaster on Wall No. 1 & Shade of Outer Wall of Police H.Q. Ground Floor, Part A

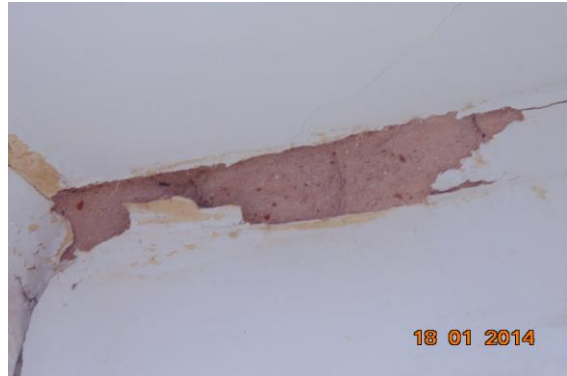
Photo 258

Peeling of Plaster on Wall No. 1 & Shade of Outer Wall of Police H.Q. Ground Floor, Part A

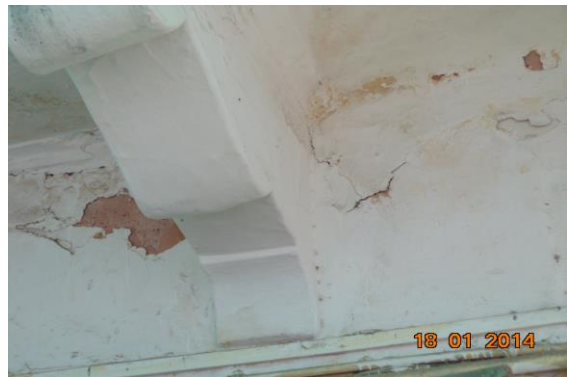
Photo 259

Peeling of Plaster on Shade of Outer Wall of Police H.Q. Ground Floor, Part A

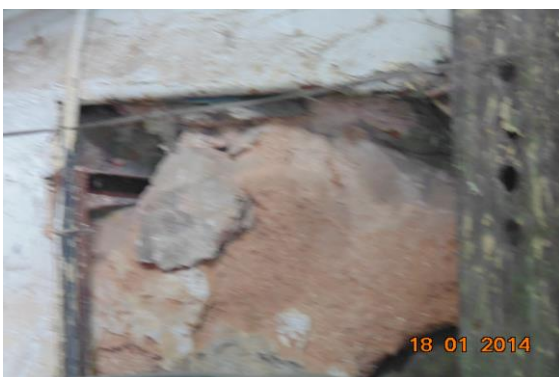
Photo 260

Peeling of Plaster on Wall No. 3 of Outer Wall of Police H.Q. Ground Floor, Part A

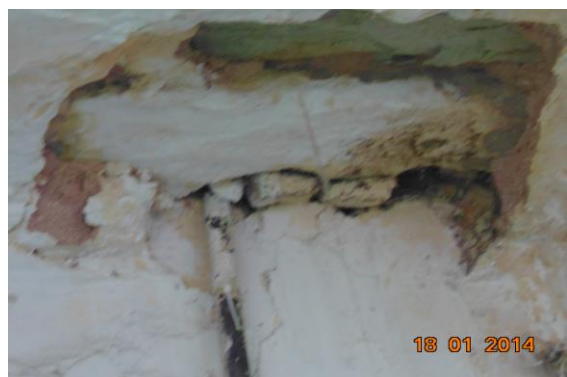
Photo 261

Damaged Portion on Wall No. 3 of Outer Wall of Police H.Q. Ground Floor, Part A

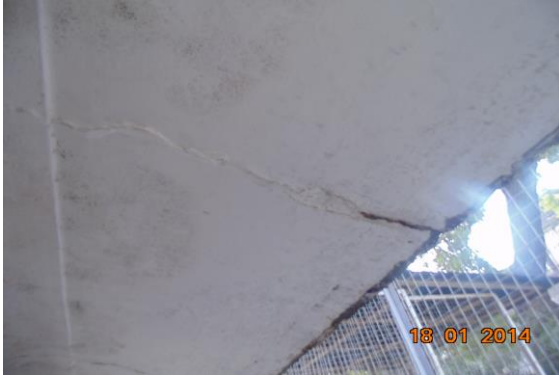
Photo 262

Peeling of Plaster on Shade of Outer Wall of Police H.Q. Ground Floor, Part A

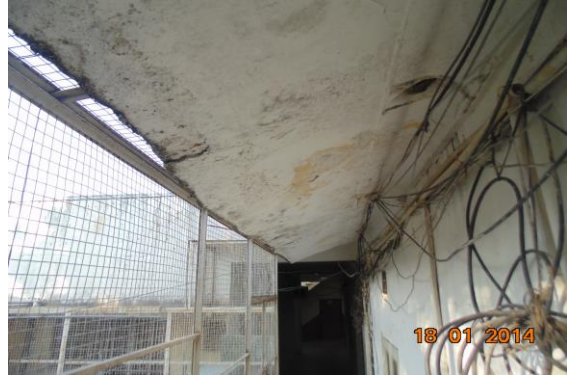
Photo 263

Peeling of Plaster on Roof of Balcony 1 of Police H.Q. First Floor, Part A

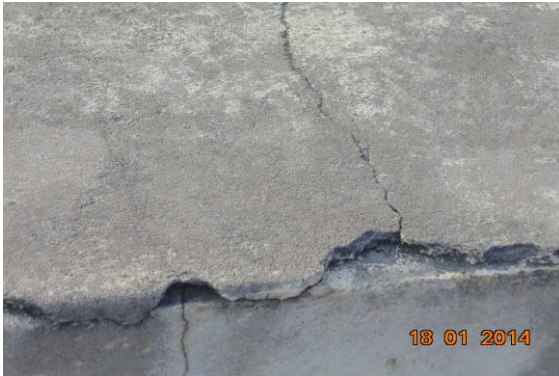
Photo 264

Peeling of Plaster on Roof of Balcony 2 of Police H.Q. First Floor, Part A

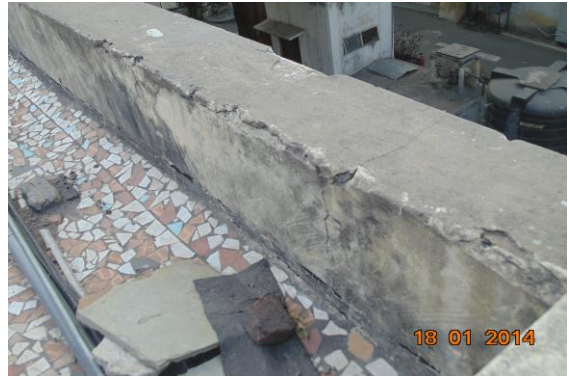
Photo 265

Peeling of Plaster on Wall No. 2 of Parapet Wall of Police H.Q. Terrace, Part A

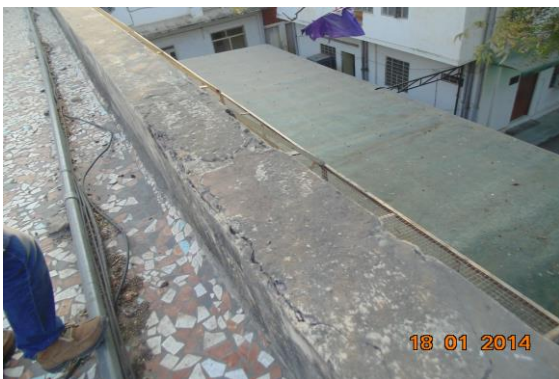
Photo 266

Peeling of Plaster on Wall No. 2 of Parapet Wall of Police H.Q. Terrace, Part A

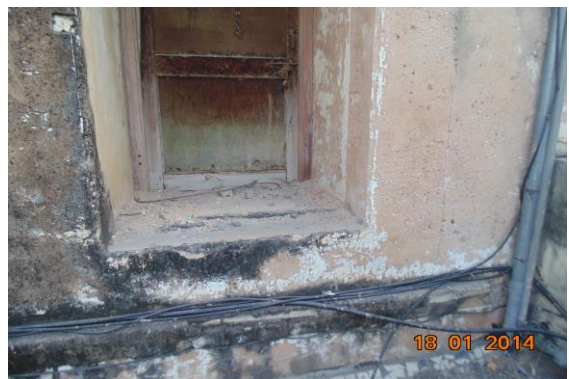
Photo 267

Peeling of Plaster on Top of Parapet Wall 1 of Police H.Q. Terrace, Part A

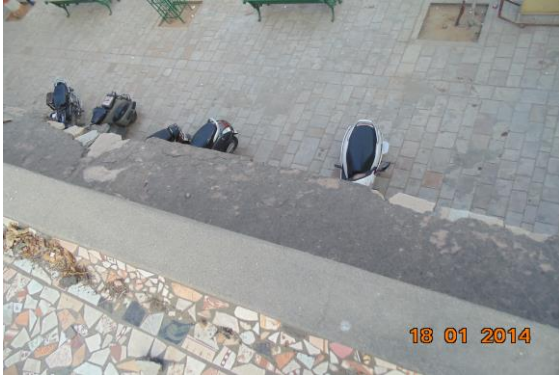
Photo 268

Peeling of Plaster on Wall No. 4 of Parapet Wall of Police H.Q. Terrace, Part A

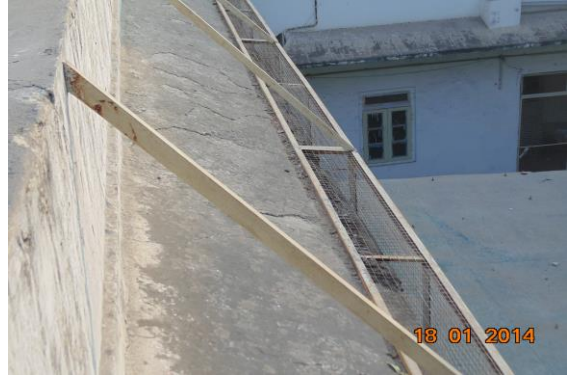
Photo 269

Peeling of Plaster on Shade of top of Terrace of Police H.Q. Terrace,
Part A

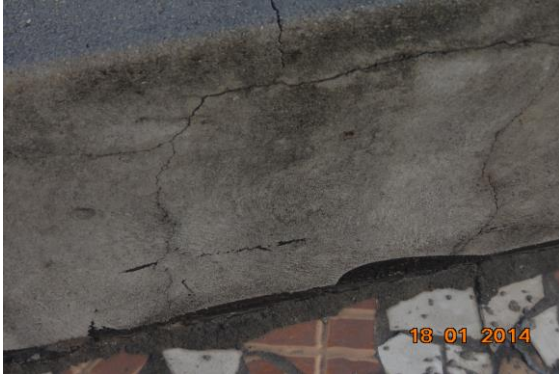
Photo 270

Peeling of Plaster on Shade of top of Terrace of Police H.Q. Terrace,
Part A

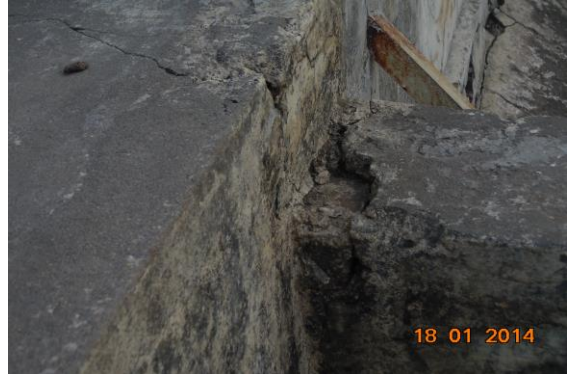
Photo 271

Plaster Crack on Wall No. 1 of Parapet Wall of Police H.Q. Terrace,
Part A

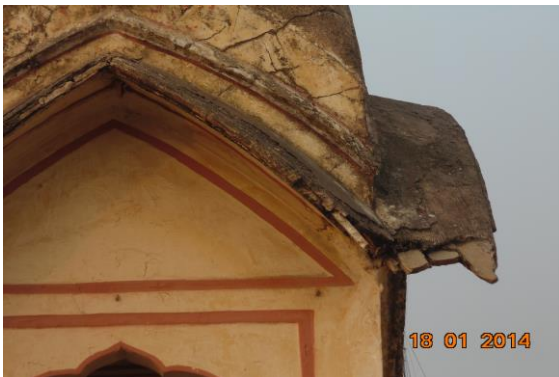
Photo 272

Peeling of Plaster on Wall No. 1 of Parapet Wall of Police H.Q. Terrace,
Part A

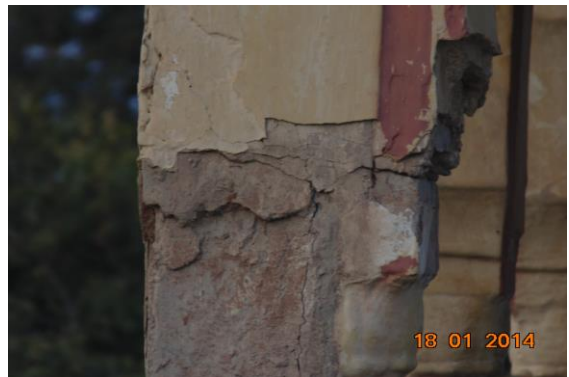
Photo 273

Peeling of Plaster on Shade of Minarets of Police H.Q. Terrace, Part A

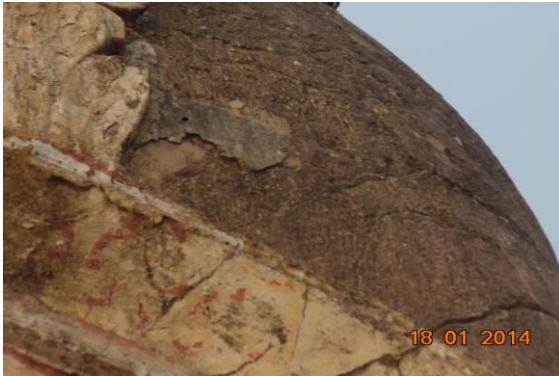
Photo 274

Peeling of Plaster on Vertical Pillar of Minarets of Police H.Q. Terrace,
Part A

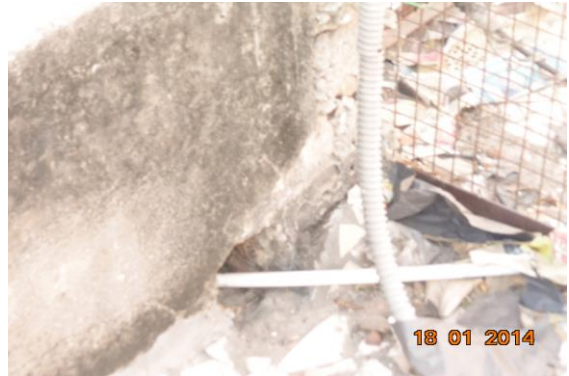
Photo 275

Peeling of Plaster on Roof of Minarets of Police H.Q. Terrace, Part A

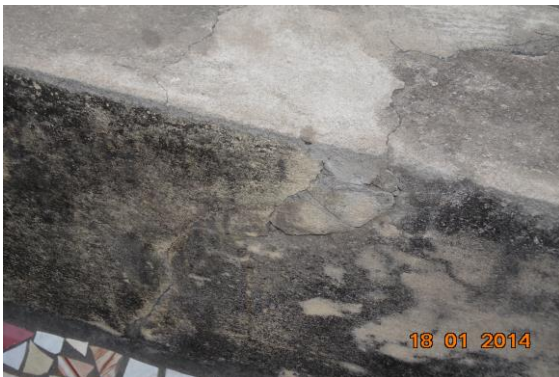
Photo 276

Peeling of Plaster on Wall No. 1 of Parapet wall of Police H.Q. Terrace, Part A

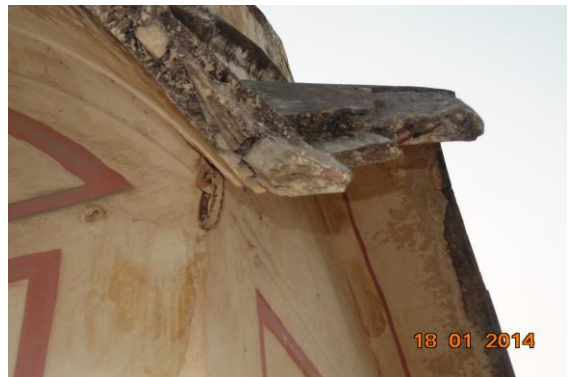
Photo 277

Peeling of Plaster on Wall No. 1 of Parapet wall of Police H.Q. Terrace, Part A

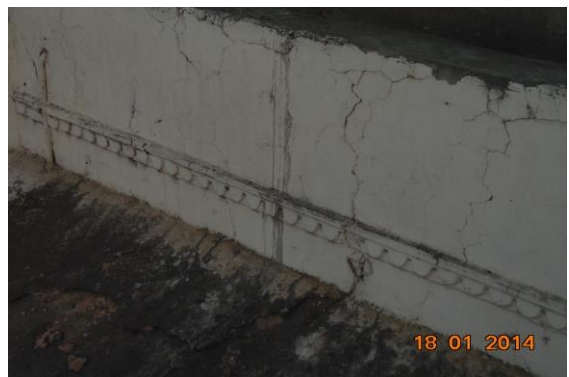
Photo 279

Peeling of Plaster on Vertical Pillar of Minarets of Police H.Q. Terrace, Part A

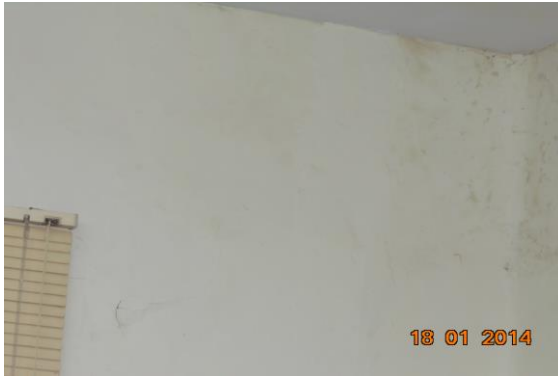
Photo 280

Peeling of Plaster on Shade of Outer Wall of Police H.Q. Terrace, Part A

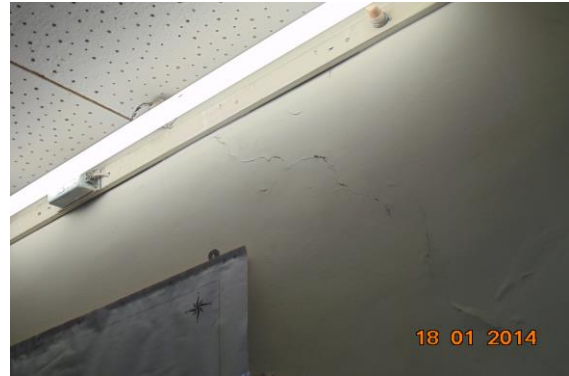
Photo 281

Dampness/Seepage on Wall No. 4 of Room No. 309 of Police H.Q. First Floor, Part C

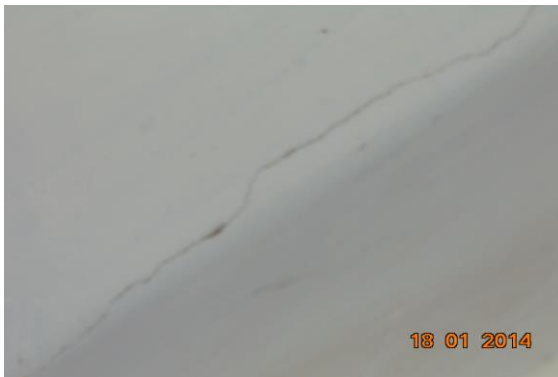
Photo 282

Plaster Crack on Wall No. 3 of Room No. 311 of Police H.Q. First Floor, Part C

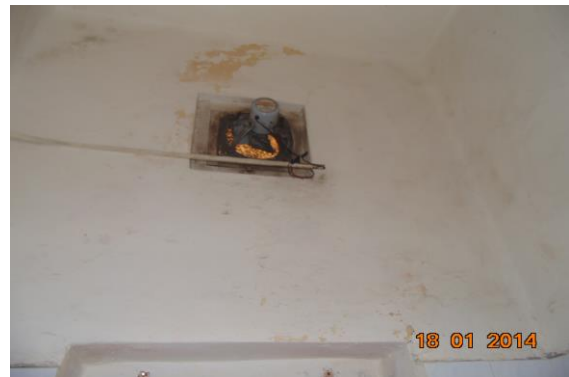
Photo 283

Plaster Crack on Roof of Store of Police H.Q. First Floor, Part C

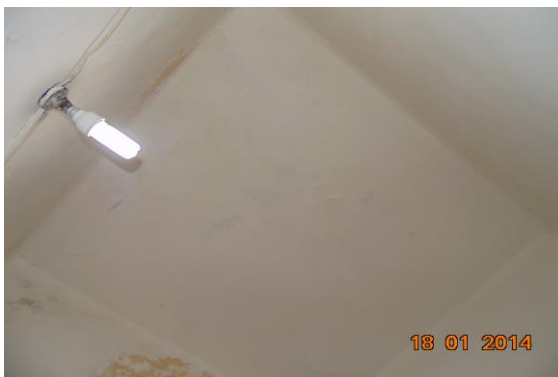
Photo 284

Peeling of Plaster on Wall No. 1 of Toilet No. 4 of Police H.Q. First Floor, Part C

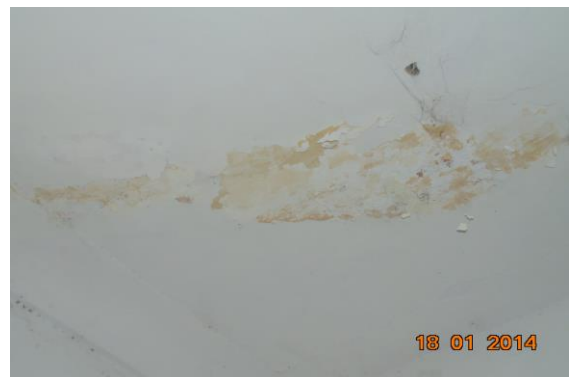
Photo 285

Peeling of Plaster on Roof of Toilet No. 4 of Police H.Q. First Floor, Part C

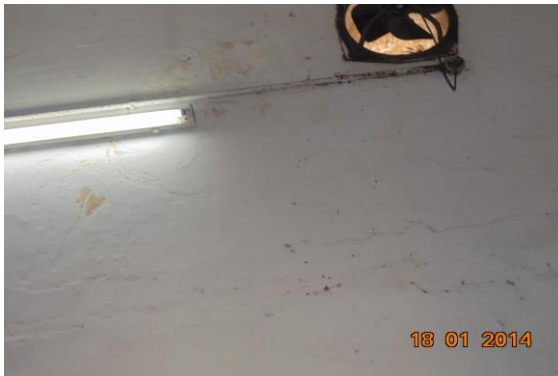
Photo 286

Peeling of Plaster on Roof of Toilet No. 6 of Police H.Q. First Floor, Part C

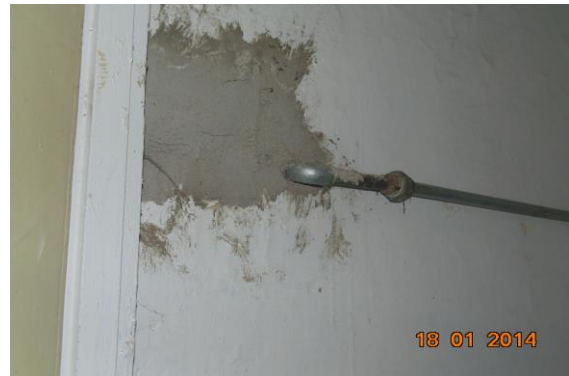
Photo 287

Peeling of Plaster on Wall No. 4 of Toilet No. 6 of Police H.Q. First Floor, Part C

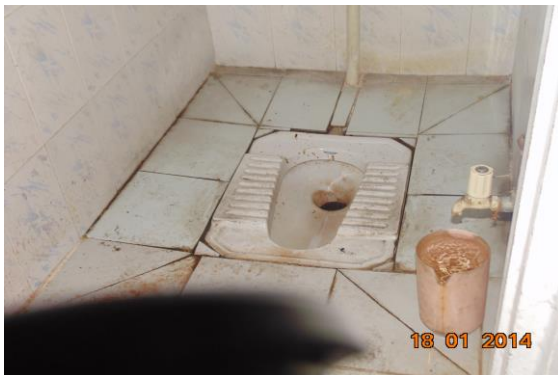
Photo 288

Peeling of Plaster on Wall No. 1 of Toilet No. 1 of Police H.Q. First Floor, Part C

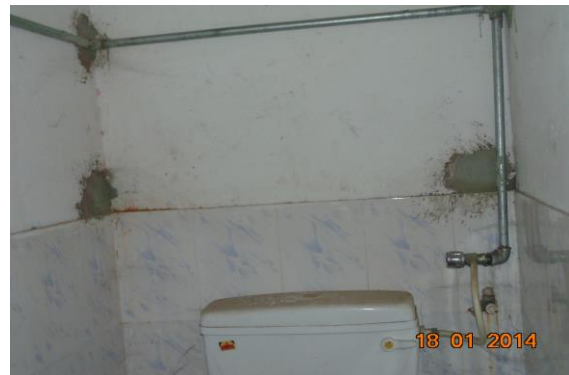
Photo 289

Damaged Portion on Floor of Toilet No. 1 of Police H.Q. First Floor, Part C

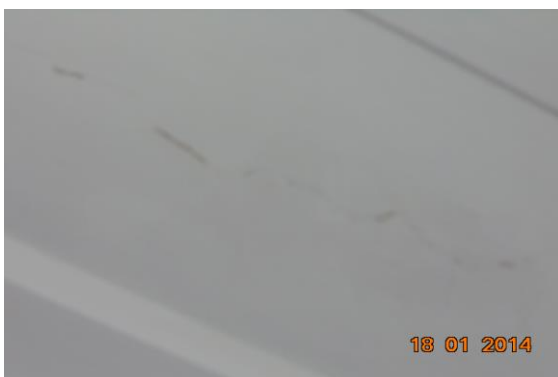
Photo 290

Peeling of Plaster on Wall No. 4 of Toilet No. 2 of Police H.Q. First Floor, Part C

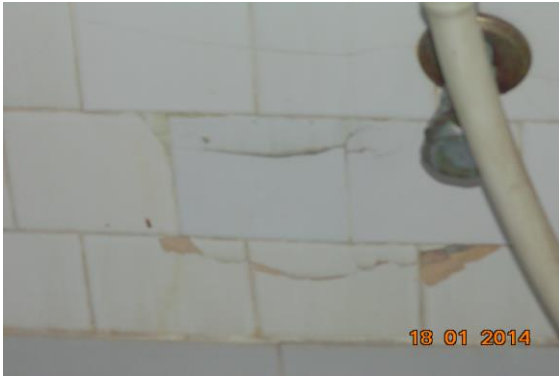
Photo 292

Damaged Portion on Wall No. 4 of Toilet No. 7 of Police H.Q. First Floor, Part C

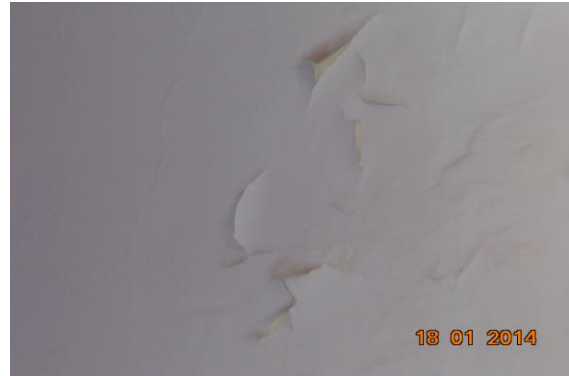
Photo 293

Peeling of Plaster on Wall No. 4 of Toilet No. 7 of Police H.Q. First Floor, Part C

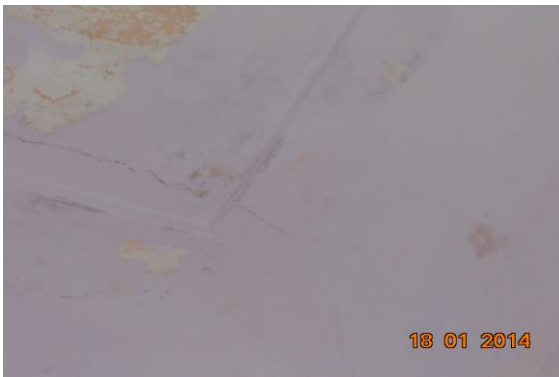
Photo 294

Peeling of Plaster on Roof of Toilet No. 7 of Police H.Q. First Floor, Part C

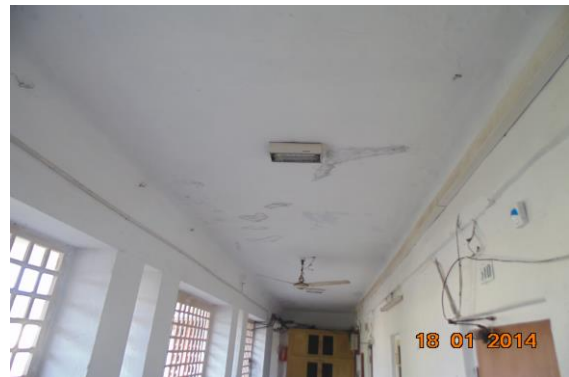
Photo 295

Peeling of Plaster on Roof of Passage 1 of Police H.Q. First Floor, Part C

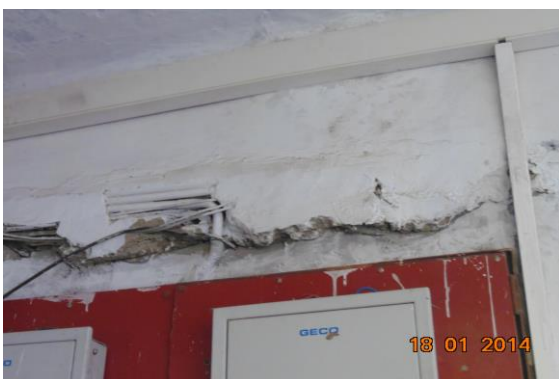
Photo 296

Peeling of Plaster on Roof of Passage 1 of Police H.Q. First Floor, Part C

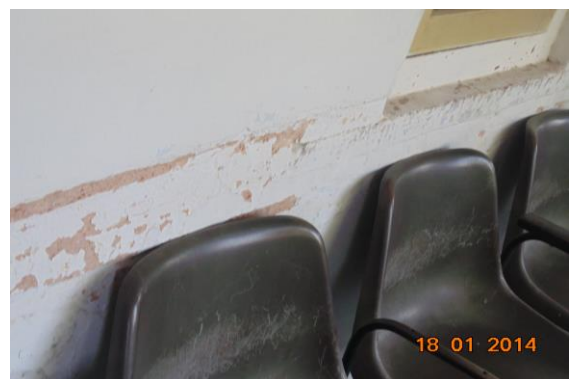
Photo 297

Peeling of Plaster on Wall No. 1 of Passage 1 of Police H.Q. First Floor, Part C

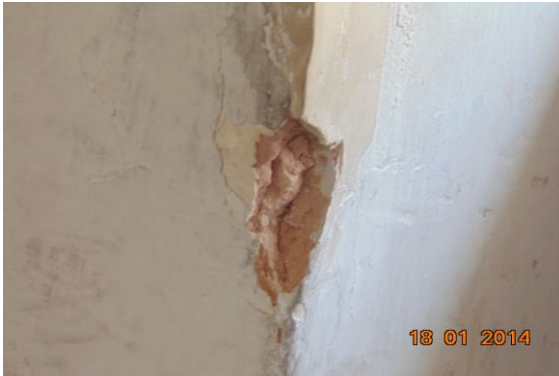
Photo 299

Peeling of Plaster on Wall No. 2 of Passage 1 of Police H.Q. First Floor, Part C

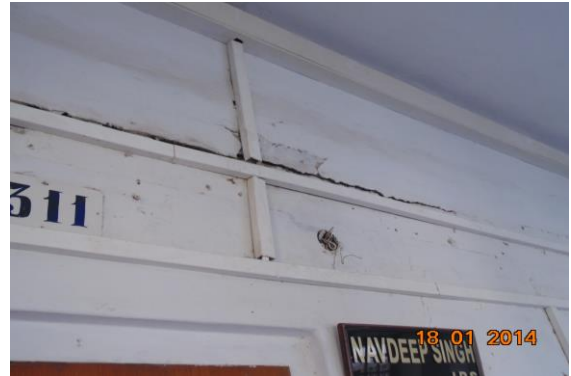
Photo 300

Peeling of Plaster on Wall No. 2 of Passage 1 of Police H.Q. First Floor, Part C

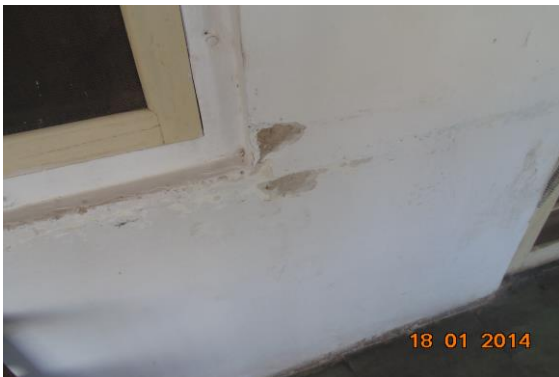
Photo 301

Peeling of Plaster on Wall No. 1 of Passage 2 of Police H.Q. First Floor, Part C

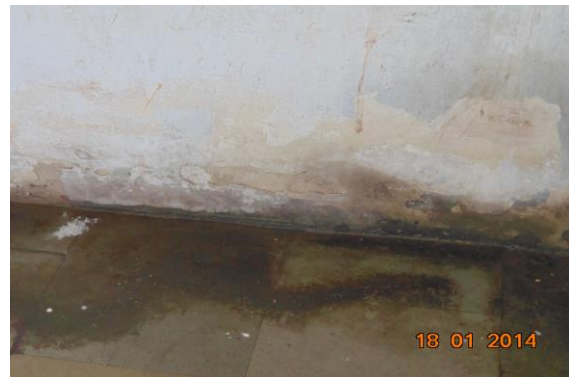
Photo 302

Peeling of Plaster on Wall No. 2 of Passage 2 of Police H.Q. First Floor, Part C

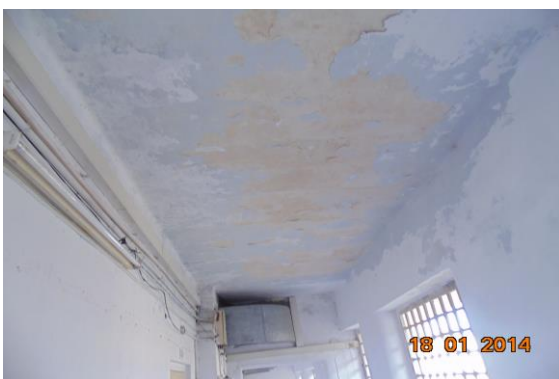
Photo 303

Peeling of Plaster on Roof of Passage 2 of Police H.Q. First Floor, Part C

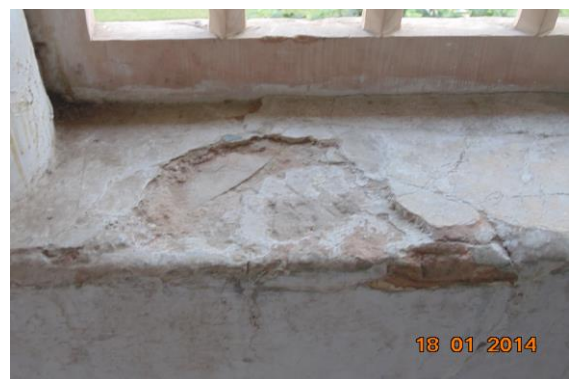
Photo 304

Peeling of Plaster on Wall No. 2 of Passage 3 of Police H.Q. First Floor, Part C

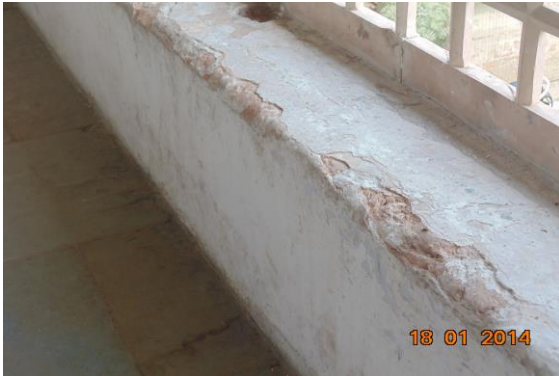
Photo 305

Peeling of Plaster on Wall No. 2 of Passage 3 of Police H.Q. First Floor, Part C

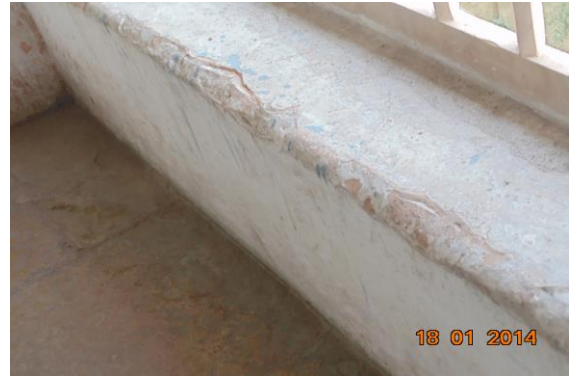
Photo 306

Peeling of Plaster on Wall No. 2 of Passage 3 of Police H.Q. First Floor, Part C

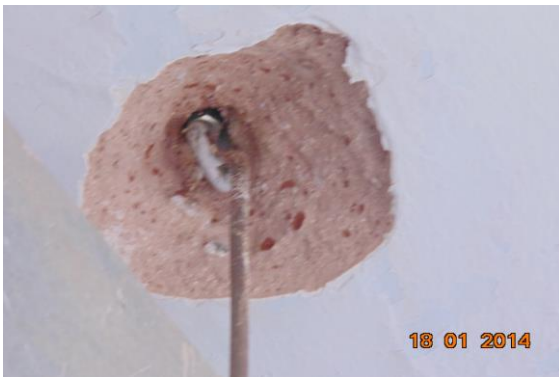
Photo 307

Peeling of Plaster on Roof of Passage 3 of Police H.Q. First Floor, Part C

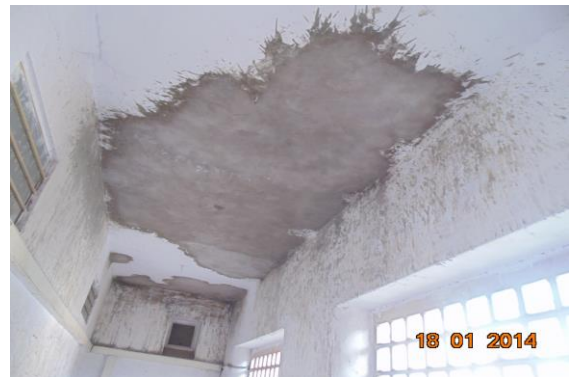
Photo 308

Peeling of Plaster on Roof of Passage 3 of Police H.Q. First Floor, Part C

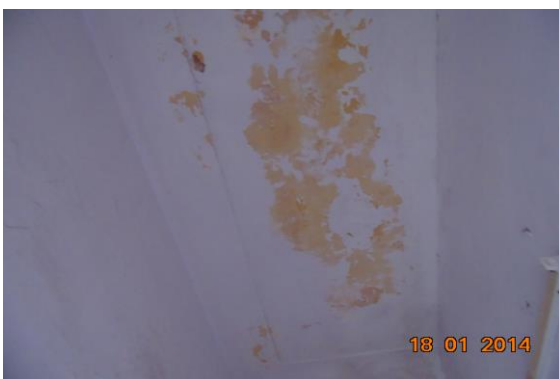
Photo 309

Peeling of Plaster on Roof of Lobby of Police H.Q. F. Floor, Part C

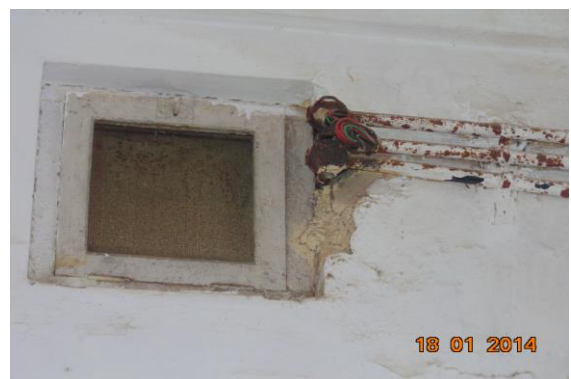
Photo 310

Peeling of Plaster on Wall No. 4 of Lobby of Police H.Q. First Floor, Part C
