Pre Building Condition Survey Report

Name and Address of Structure :	Choti Chopar to Badi Chopar (UP Line)
---------------------------------	---------------------------------------

Name of the Project	Contract JMRC-UG1B “Design and Construction of Tunnel between Chandpole and Badi Chouper and reverse line by Shield TBM, Underground Metro Stations at Choti Chouper and Badi Chouper by Cut and Cover Methods on East West Corridor of Jaipur Metro Rail Corporation Limited .”	
Owner :

Shoping Complex - Shop No. 169-188
Tripolia Bazar
Jaipur
Unique ID: CC BC UP 0001

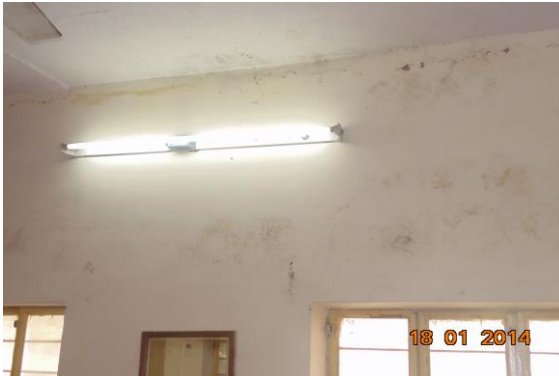
Photo 311

Dampness/Seepage of Room No, 409 of Police H.Q. First Floor, Part A

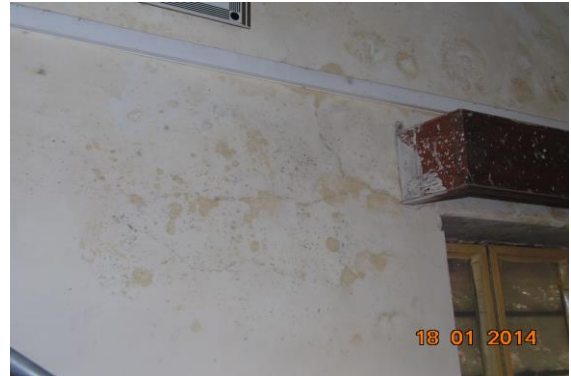
Photo 312

Dampness/Seepage on Wall No. 3 of Room No, 409 of Police H.Q. First Floor, Part A

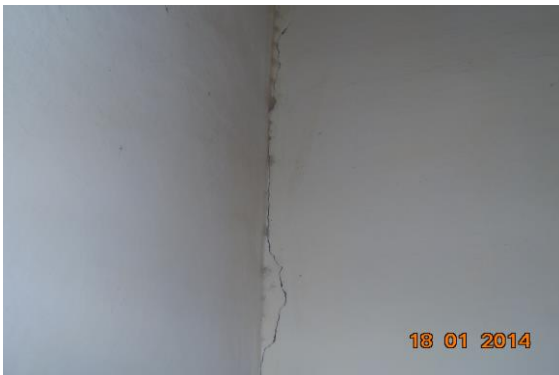
Photo 313

Plaster Crack on Wall No. 2 & 4 of Room No, 409 of Police H.Q. First Floor, Part A

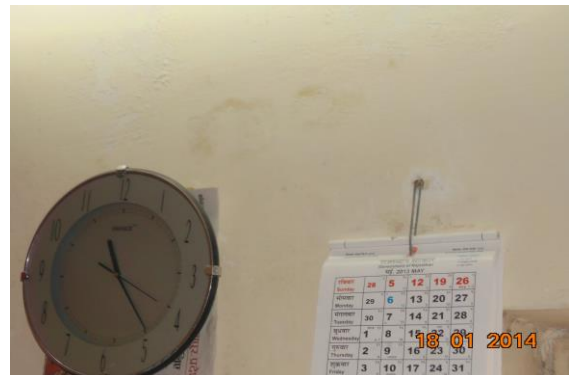
Photo 314

Dampness/Seepage on Wall No. 4 of Room No, 410 of Police H.Q. First Floor, Part A

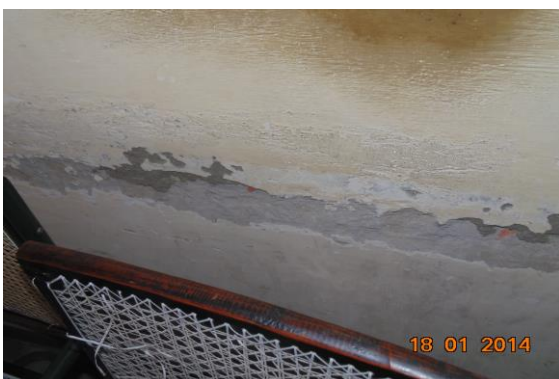
Photo 315

Peeling of Plaster on Wall No. 2 of Room No, 411 of Police H.Q. First Floor, Part A

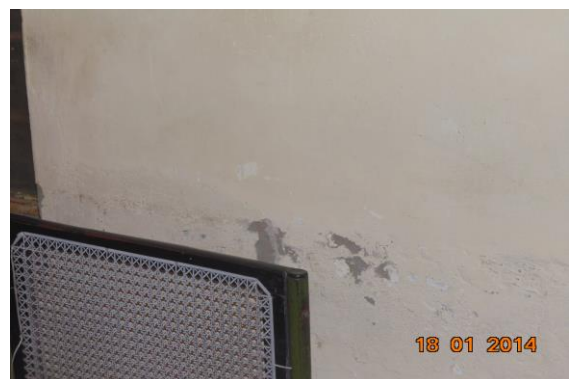
Photo 316

Peeling of Plaster on Wall No. 4 of Room No, 411 of Police H.Q. First Floor, Part A

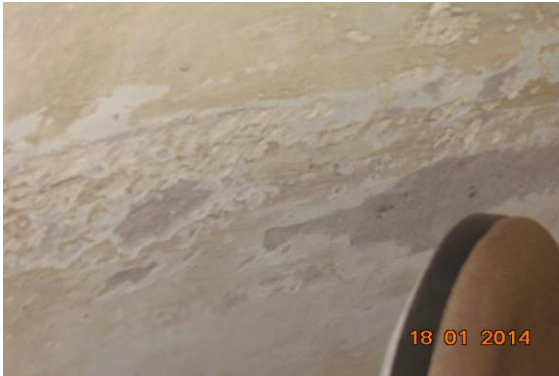
Photo 317

Peeling of Plaster on Wall No. 3 of Room No, 411 of Police H.Q. First Floor, Part A

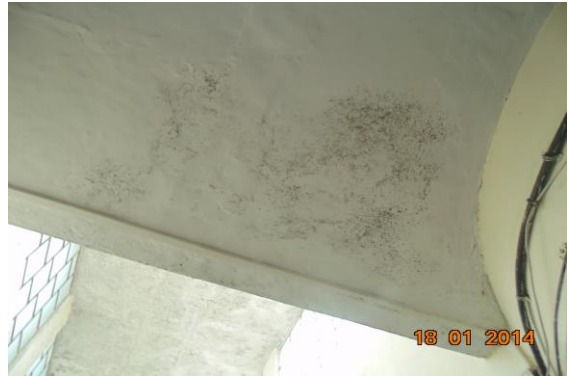
Photo 318

Dampness/Seepage on Roof of Passage 1 of Police H.Q. First Floor, Part A

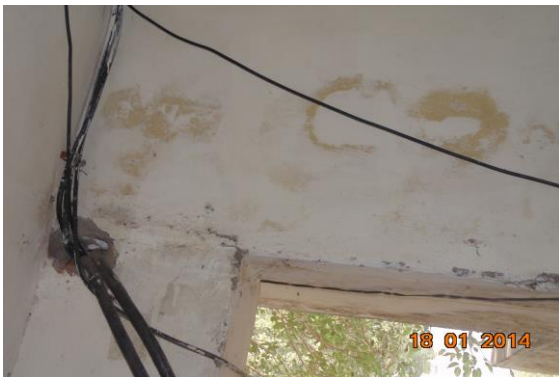
Photo 319

Dampness/Seepage on Wall No. 3 of Passage 1 of Police H.Q. First Floor, Part A

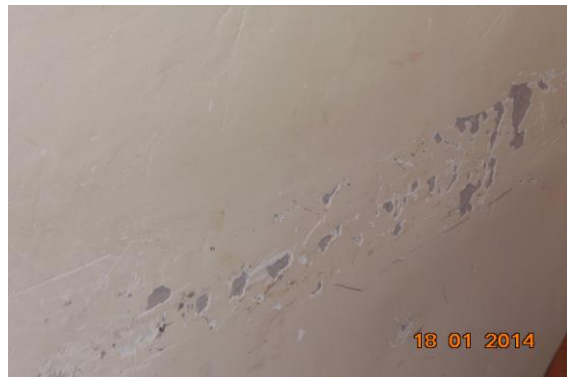
Photo 320

Peeling of Plaster on Wall No. 1 of Room No, 408 of Police H.Q. First Floor, Part A

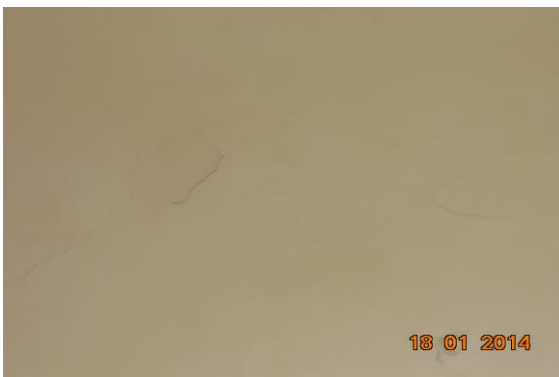
Photo 321

Peeling of Plaster on Wall No. 4 of Room No, 407 of Police H.Q. First Floor, Part A

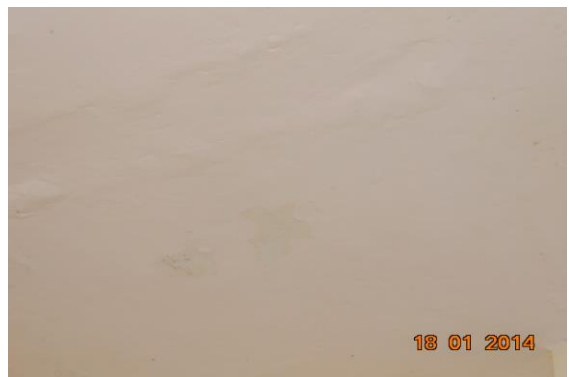
Photo 322

Dampness/Seepage on Roof of Toilet No. 1 of Police H.Q. First Floor, Part A

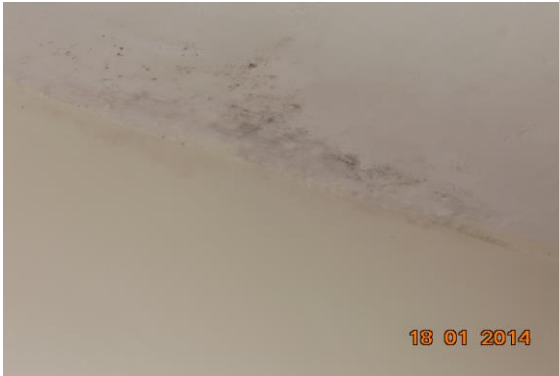
Photo 323

Dampness/Seepage on Roof of Room No, 406 of Police H.Q. First Floor, Part A

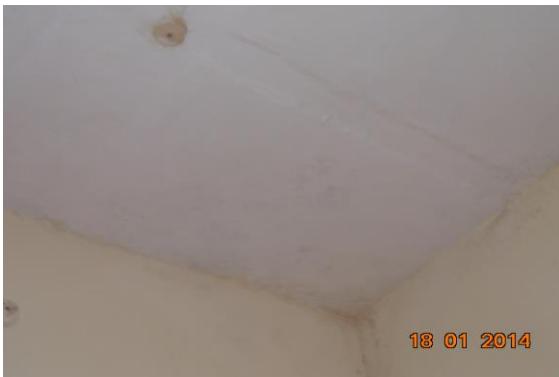
Photo 325

Dampness/Seepage on Roof of Toilet No. 2 of Police H.Q. First Floor, Part A

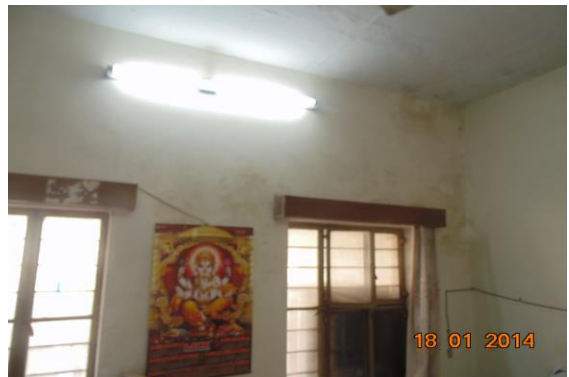
Photo 326

Dampness/Seepage on Wall No. 4 of Room No, 412 of Police H.Q. First Floor, Part A

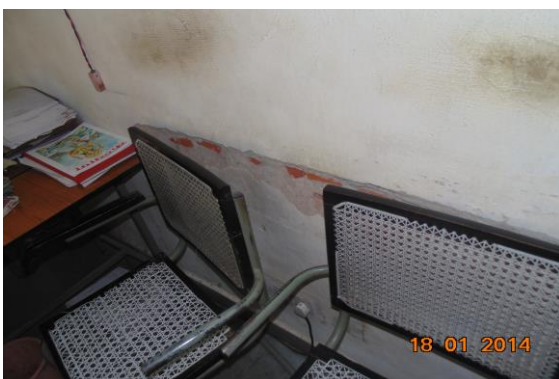
Photo 327

Peeling of Plaster on Wall No. 3 of Room No, 412 of Police H.Q. First Floor, Part A

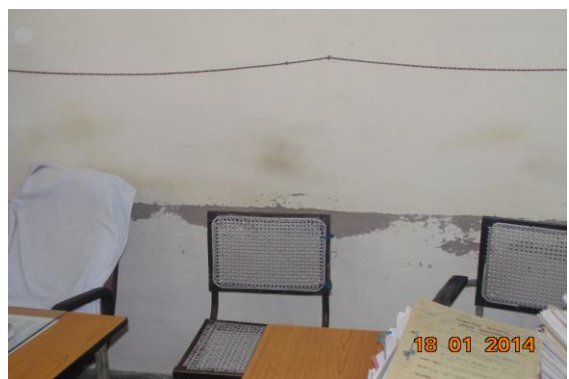
Photo 328

Peeling of Plaster on Wall No. 2 of Room No, 412 of Police H.Q. First Floor, Part A

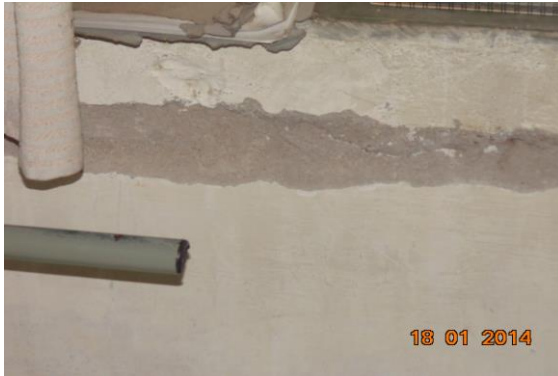
Photo 329

Peeling of Plaster on Wall No. 4 of Room No. 412 of Police H.Q. First Floor, Part A

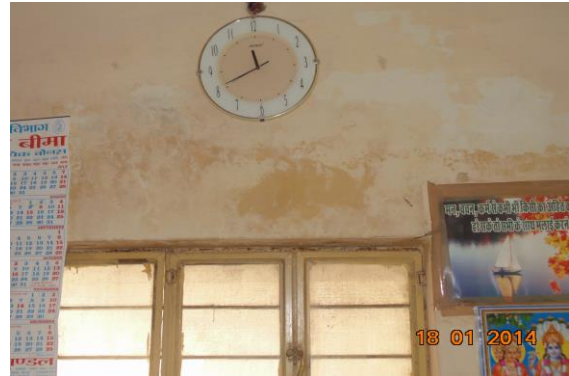
Photo 330

Dampness/Seepage on Wall No. 4 of Room No. 413 A of Police H.Q. First Floor, Part A

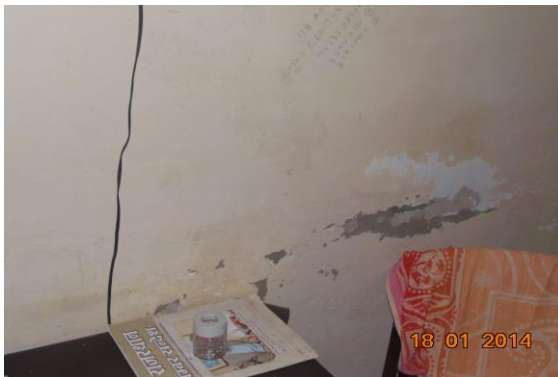
Photo 331

Peeling of Plaster on Wall No. 1 of Room No. Room No. 413 A of Police H.Q. First Floor, Part A

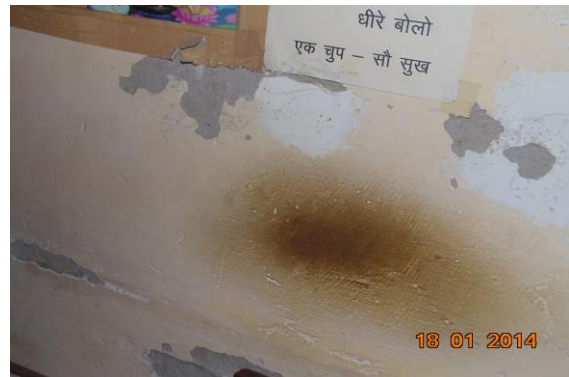
Photo 332

Peeling of Plaster on Wall No. 2 of Room No. 413 A of Police H.Q. First Floor, Part A

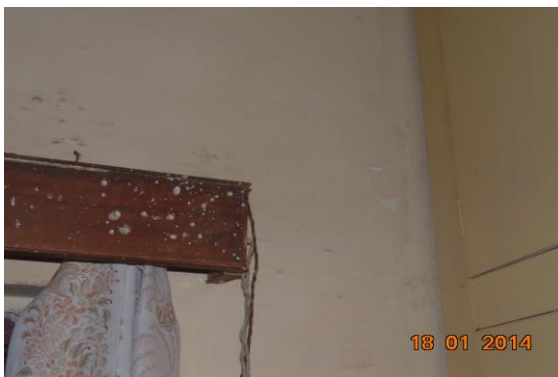
Photo 333

Peeling of Plaster on Wall No. 3 of Room No. 413 A of Police H.Q. First Floor, Part A

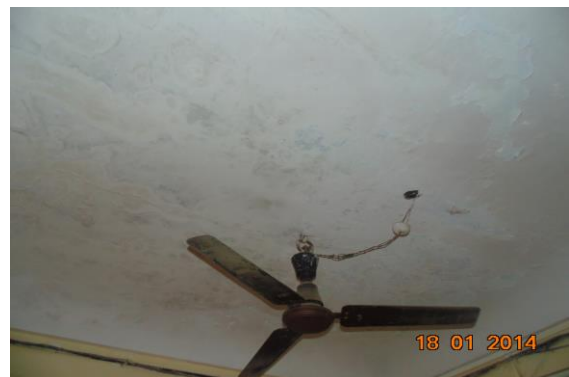
Photo 334

Dampness/Seepage on Roof of lobby 1 of Police H.Q. First Floor, Part A

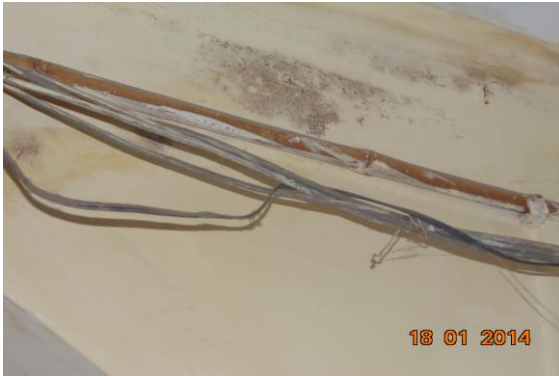
Photo 335

Dampness/Seepage on Wall No. 3 of lobby 1 of Police H.Q. First Floor, Part A

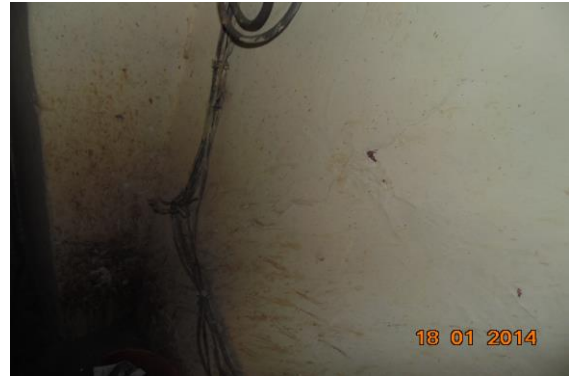
Photo 336

Plaster Crack on Wall No. 4 of lobby 1 of Police H.Q. First Floor, Part A

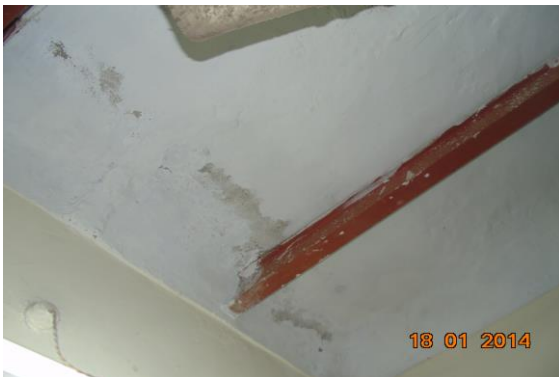
Photo 337

Dampness/Seepage on Roof of Room No, 413 B of Police H.Q. First Floor, Part A

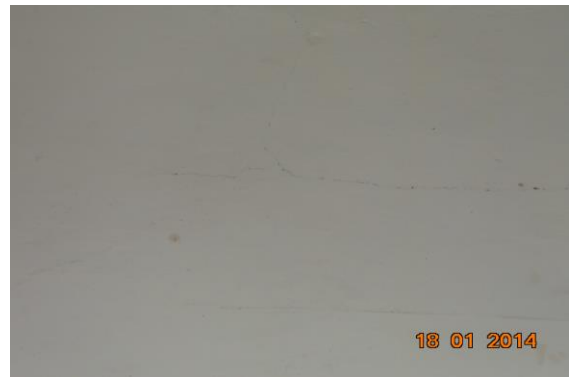
Photo 338

Plaster Crack on Wall No. 3 of Room No, 413 B of Police H.Q. First Floor, Part A

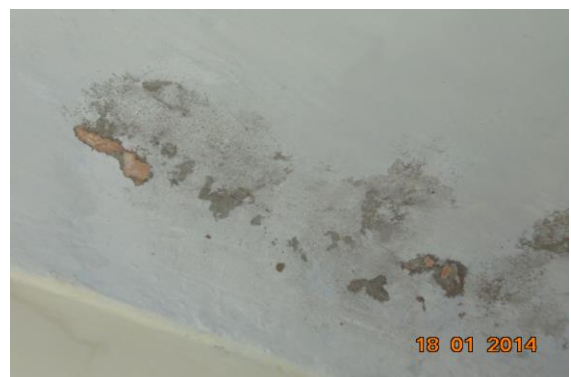
Photo 339

Plaster Crack on Wall No. 4 of Room No, 413 B of Police H.Q. First Floor, Part A

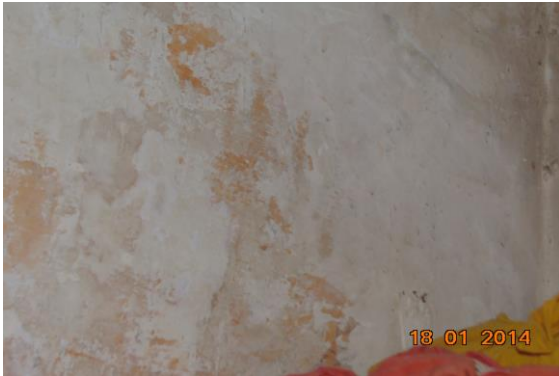
Photo 340

Peeling of Plaster on Roof of Police H.Q. First Floor, Part A

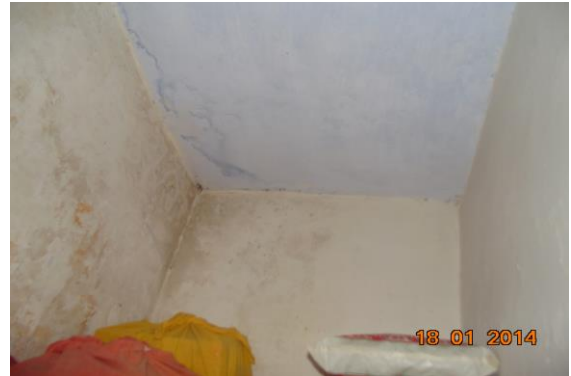
Photo 341

Dampness/Seepage on Wall No. 4 of Store 1 of Police H.Q. First Floor, Part A

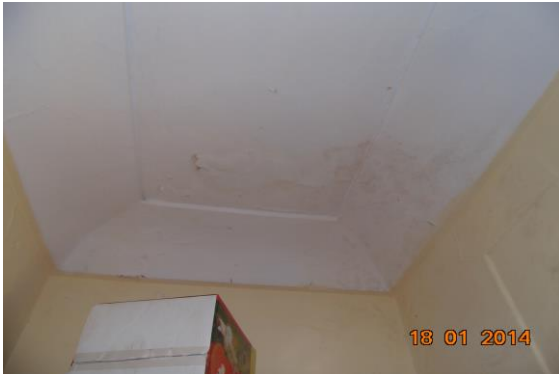
Photo 342

Dampness/Seepage on Wall No. 2, 4 & Roof of Store 1 of Police H.Q. First Floor, Part A

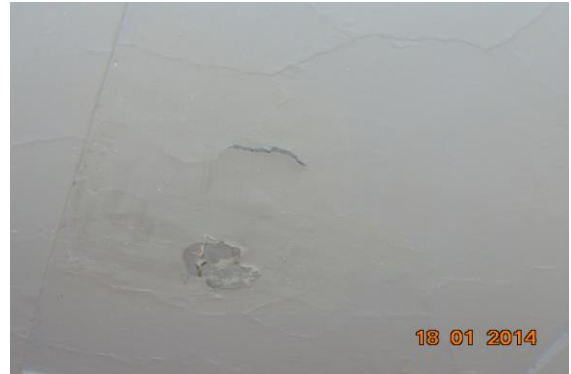
Photo 343

Dampness/Seepage on Roof of Room No, 396 of Police H.Q. First Floor, Part A

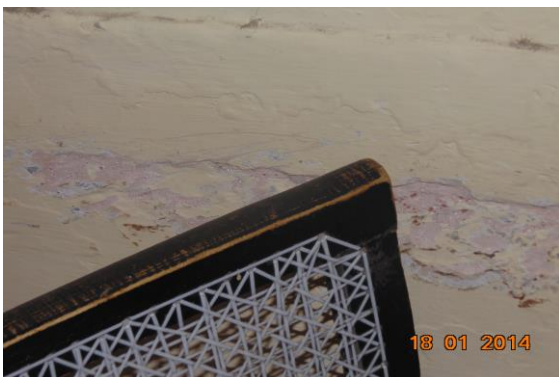
Photo 344

Peeling of Plaster on Wall No. 4 of Room No, 396 of Police H.Q. First Floor, Part A

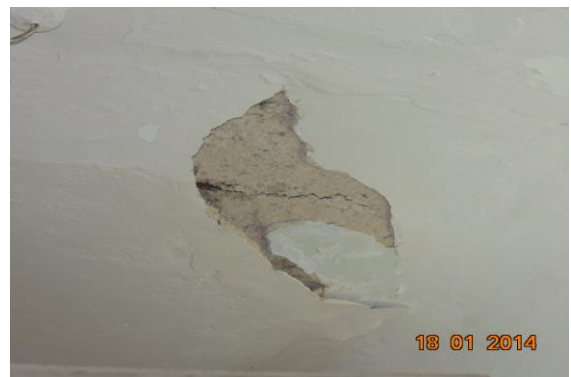
Photo 345

Peeling of Plaster on Wall No. 4 of Room No, 396 of Police H.Q. First Floor, Part A

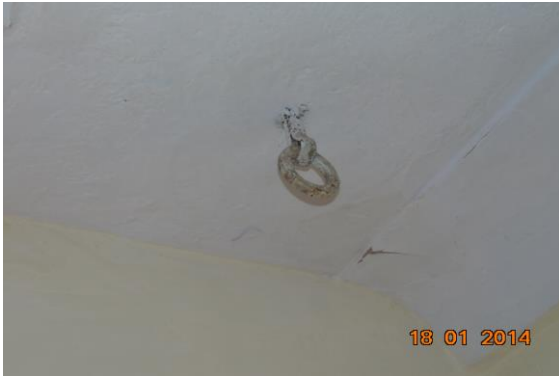
Photo 346

Peeling of Plaster on Roof of Room No, 397 of Police H.Q. First Floor, Part A

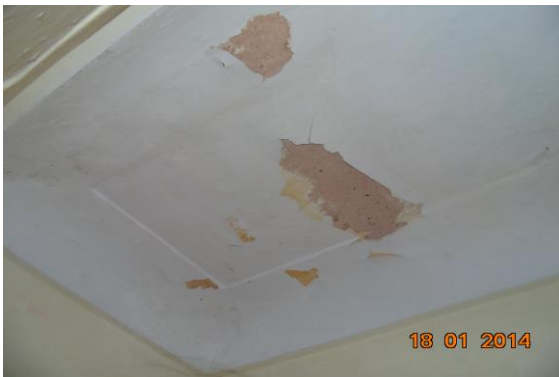
Photo 348

Peeling of Plaster on Floor of Room No. 397, Part A of Police H.Q. First Floor, Part A

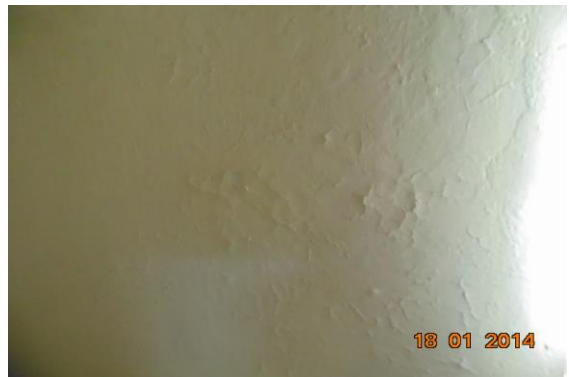
Photo 349

Peeling of Plaster on Roof of Toilet No. 3 of Police H.Q. First Floor, Part A

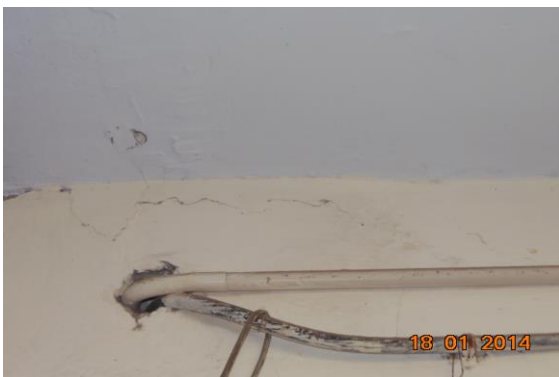
Photo 350

Peeling of Plaster on Wall No. 4 of Room No. 397, Part B of Police H.Q. First Floor, Part A

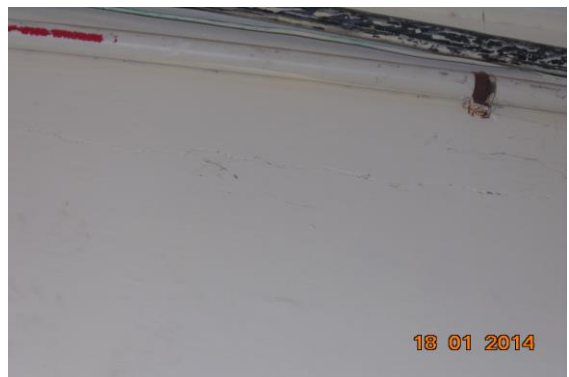
Photo 351

Plaster Crack on Wall No. 2 of Passage 1 of Police H.Q. First Floor, Part A

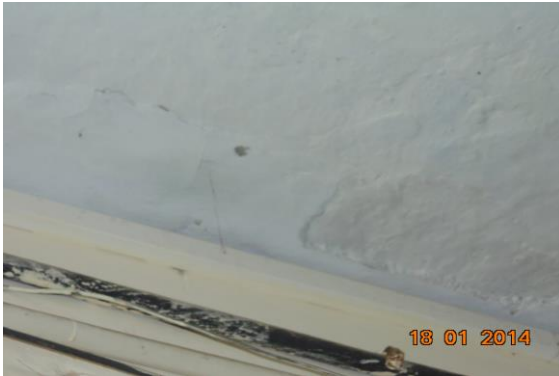
Photo 352

Plaster Crack on Wall No. 2 of Passage 2 of Police H.Q. First Floor, Part A

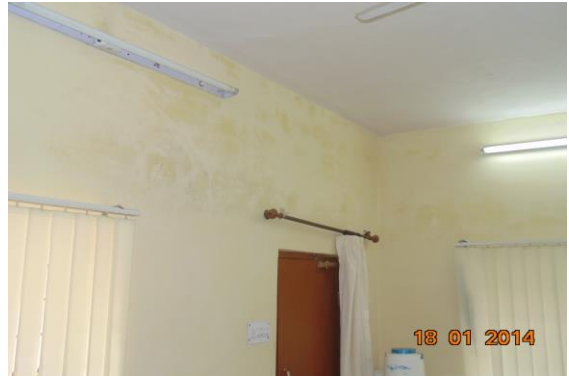
Photo 353

Peeling of Plaster on Roof of Passage 2 of Police H.Q. First Floor, Part A

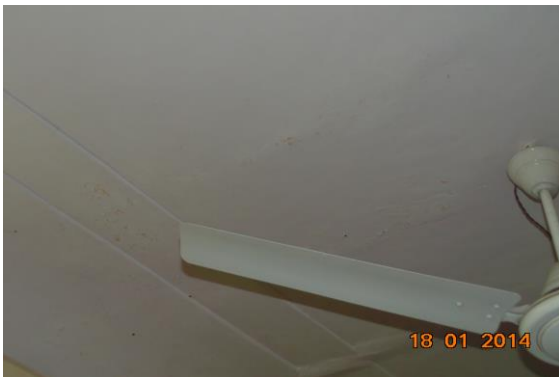
Photo 354

Dampness/Seepage on Wall No. 1 & 4 of Room No, 431 of Police H.Q. First Floor, Part A

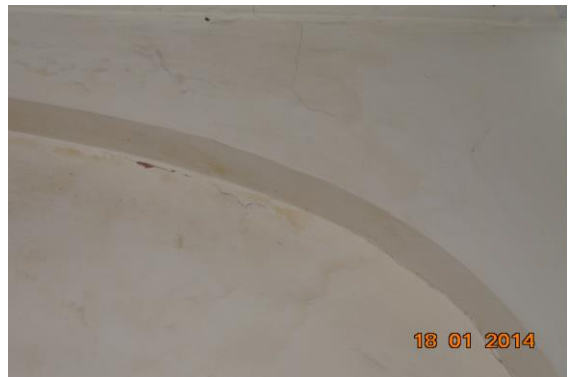
Photo 355

Peeling of Plaster on Roof of Room No, 398 of Police H.Q. First Floor, Part A

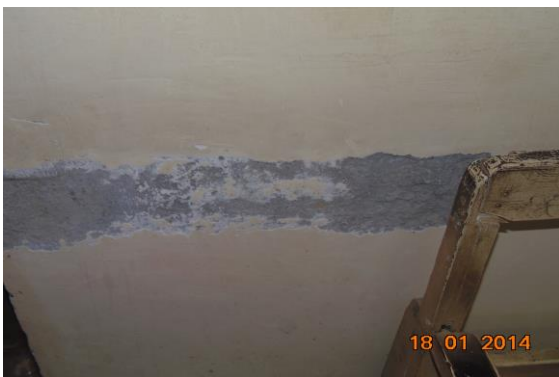
Photo 356

Plaster Crack on Wall No. 3 of Room No, 398 of Police H.Q. First Floor, Part A

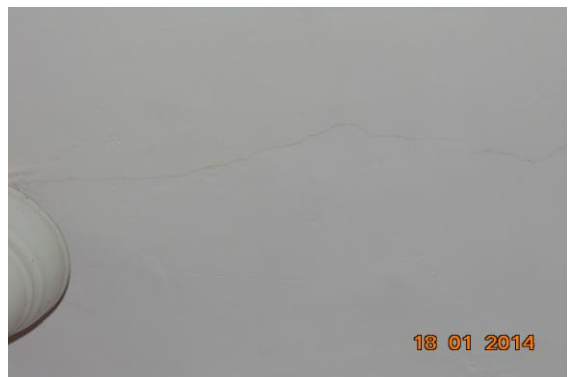
Photo 357

Peeling of Plaster on Wall No. 4 of Room No, 398 of Police H.Q. First Floor, Part A

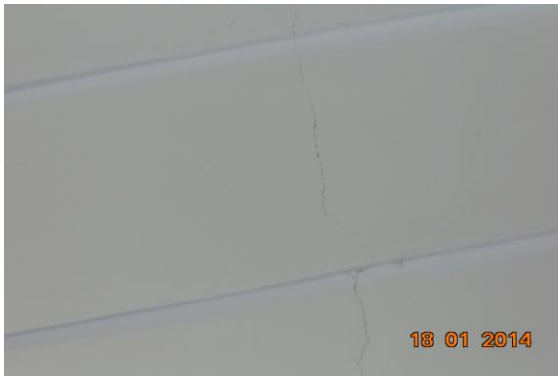
Photo 358

Plaster Crack on Roof of Room No, 398 of Police H.Q. First Floor, Part A

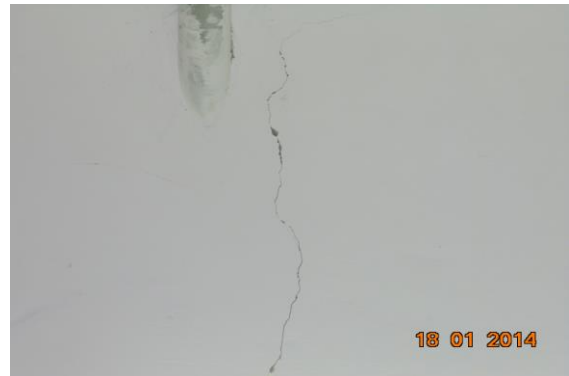
Photo 359

Plaster Crack on Roof of Room No. 398 of Police H.Q. First Floor, Part A

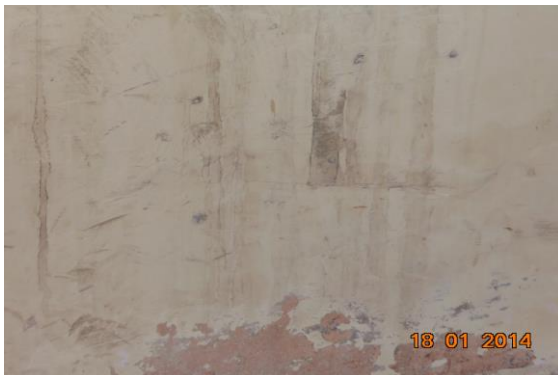
Photo 360

Plaster Crack on Roof of Room No. 398 of Police H.Q. First Floor, Part A

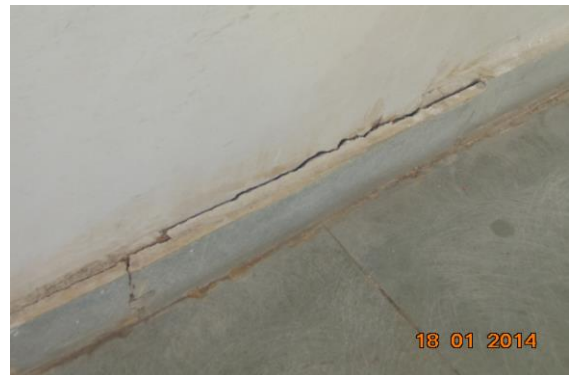
Photo 361

Peeling of Plaster on Wall No. 4 of Room No, 398 A of Police H.Q. First Floor, Part A

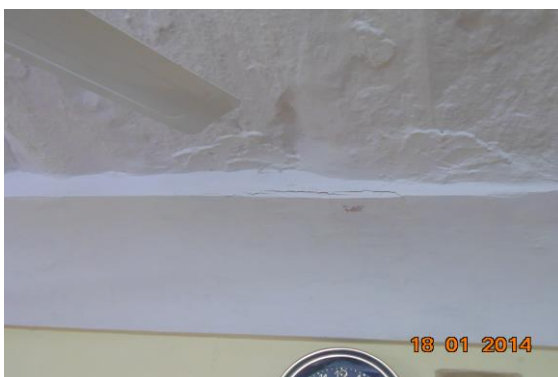
Photo 362

Damaged Portion on Wall No. 1 of Balcony 1 of Police H.Q. First Floor, Part A

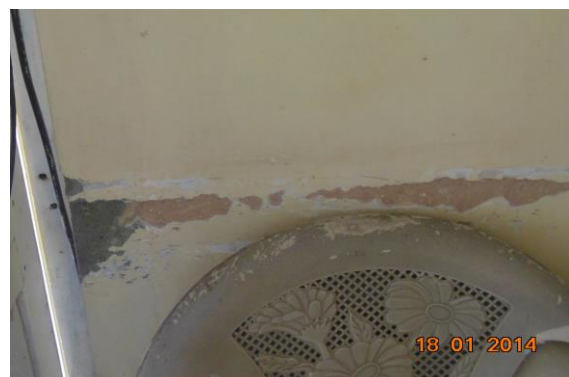
Photo 363

Plaster Crack on Roof of Room No, 399 of Police H.Q. First Floor, Part A

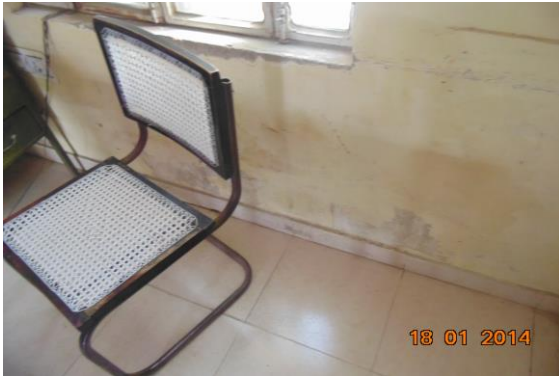
Photo 364

Peeling of Plaster on Wall No. 3 of Room No, 399 of Police H.Q. First Floor, Part A

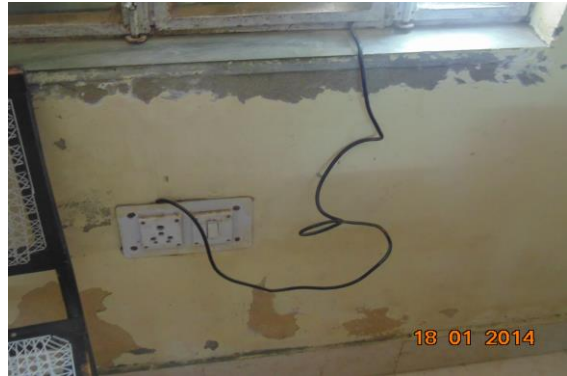
Photo 365

Peeling of Plaster on Wall No. 4 of Room No, 399, Part A of Police H.Q. First Floor, Part A

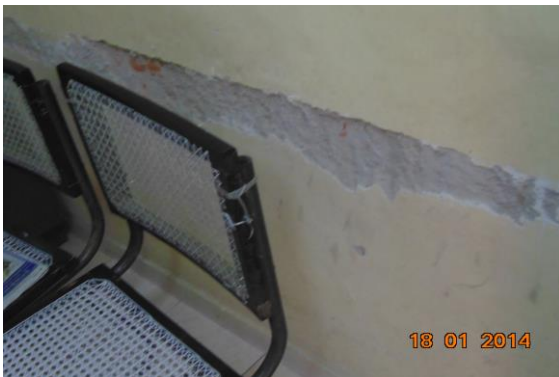
Photo 366

Peeling of Plaster on Wall No. 4 of Room No, 399, Part B of Police H.Q. First Floor, Part A

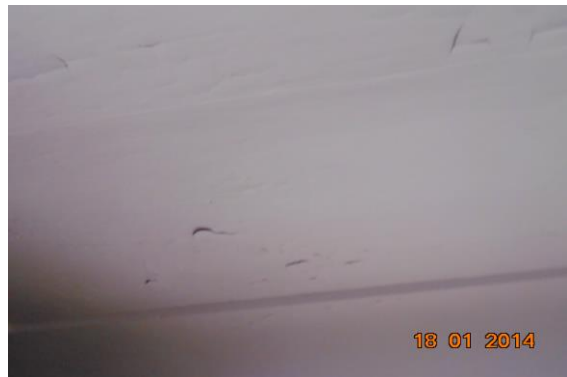
Photo 367

Peeling of Plaster on Wall No. 2 of Room No, 400 of Police H.Q. First Floor, Part A

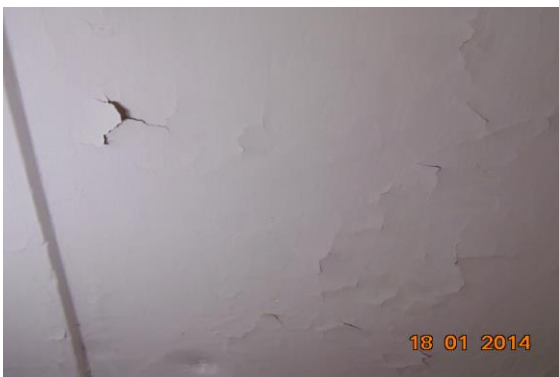
Photo 368

Peeling of Plaster on Roof of Toilet No. 4 of Police H.Q. First Floor, Part A

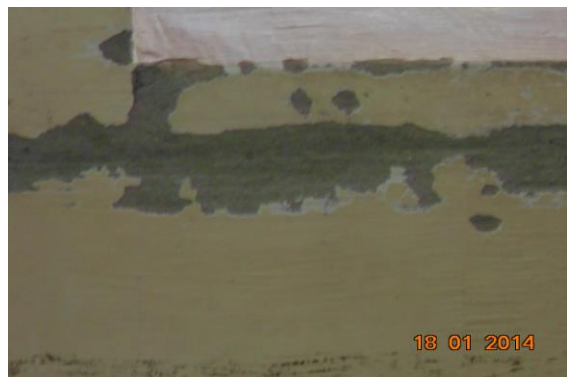
Photo 369

Peeling of Plaster on Roof of Toilet No. 4 of Police H.Q. First Floor, Part A

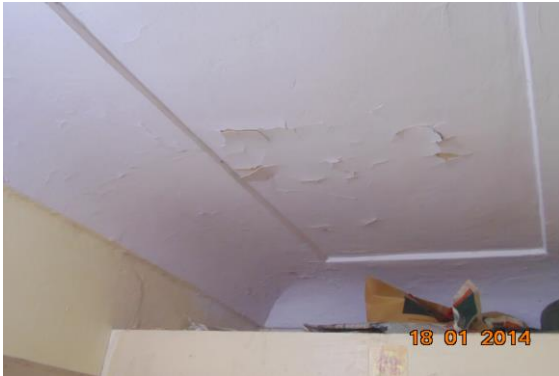
Photo 370

Peeling of Plaster on Wall No. 3 of Room No, 400 of Police H.Q. First Floor, Part A

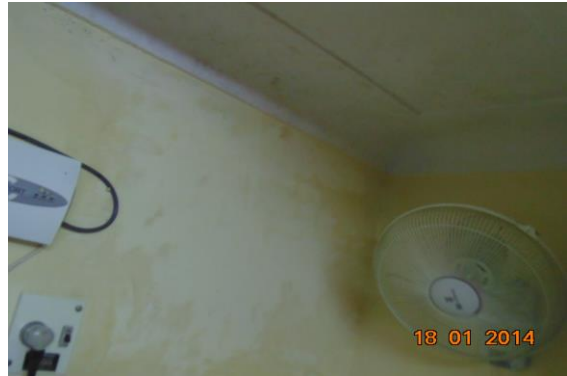
Photo 371

Peeling of Plaster on Roof of Room No, 400, Part A of Police H.Q. First Floor, Part A

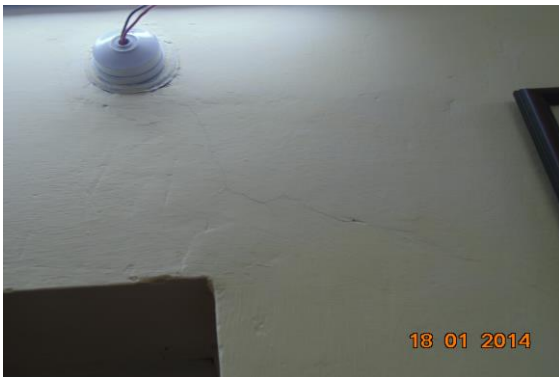
Photo 372

Dampness/Seepage on Wall No. 4 & Roof of Room No, 400, Part B of Police H.Q. First Floor, Part A

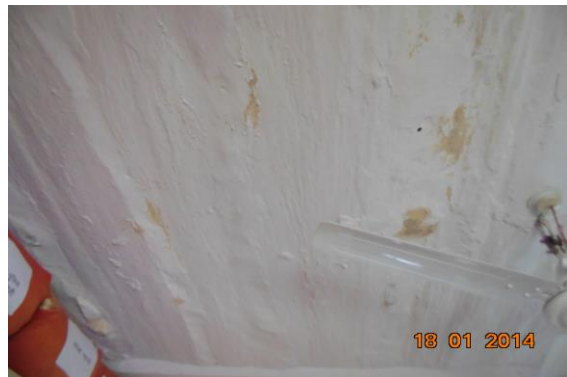
Photo 373

Plaster Crack on Wall No. 3 of Room No, 400, Part B of Police H.Q. First Floor, Part A

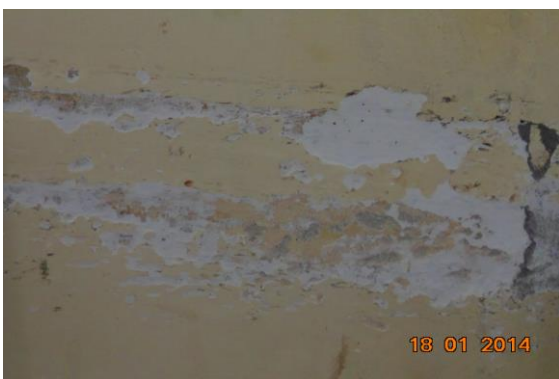
Photo 374

Peeling of Plaster on Roof of Room No, 401 of Police H.Q. First Floor, Part A

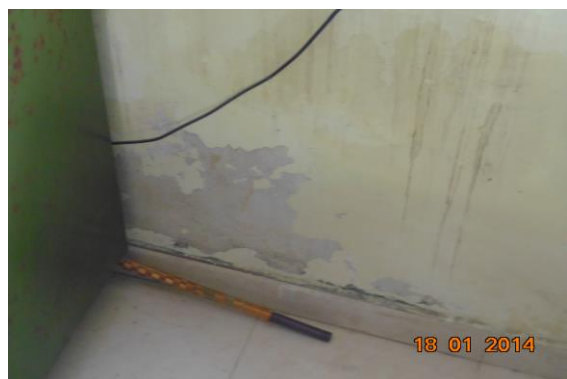
Photo 375

Peeling of Plaster on Wall No. 4 of Room No, 401 of Police H.Q. First Floor, Part A

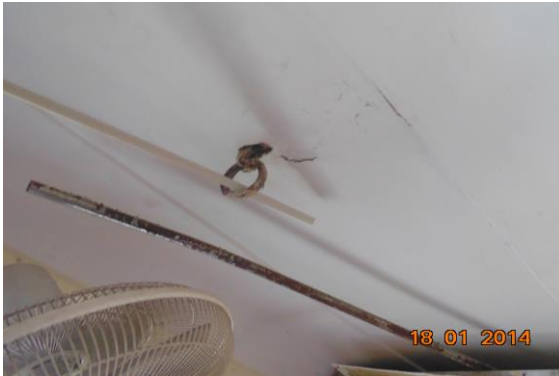
Photo 376

Peeling of Plaster on Wall No. 4 of Room No, 401, Part A of Police H.Q. First Floor, Part A

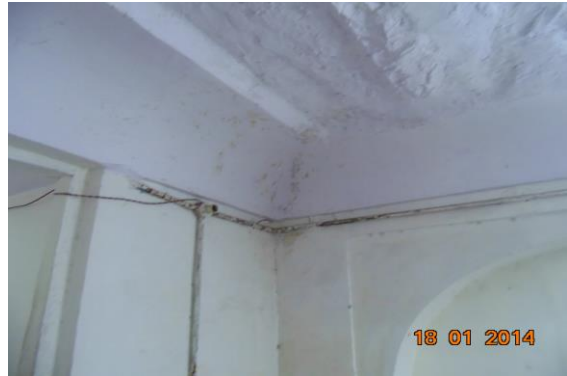
Photo 377

Peeling of Plaster on Roof of Room No, 401, Part C of Police H.Q. First Floor, Part A

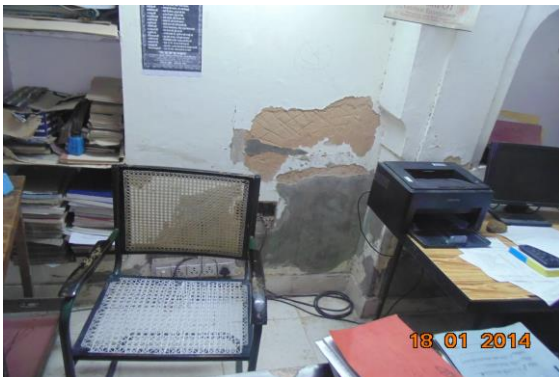
Photo 379

Peeling of Plaster on Wall No. 3 of Room No, 402 of Police H.Q. First Floor, Part A

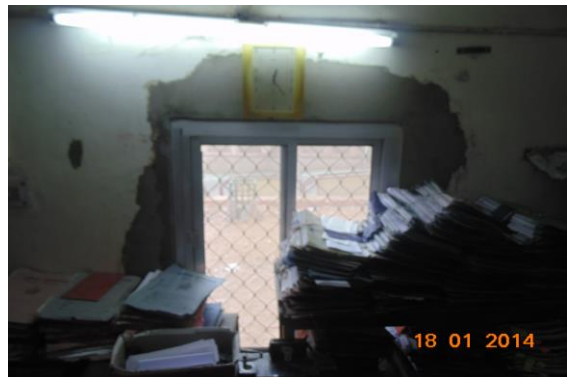
Photo 380

Peeling of Plaster on Wall No. 4 of Room No, 402, Part B of Police H.Q. First Floor, Part A

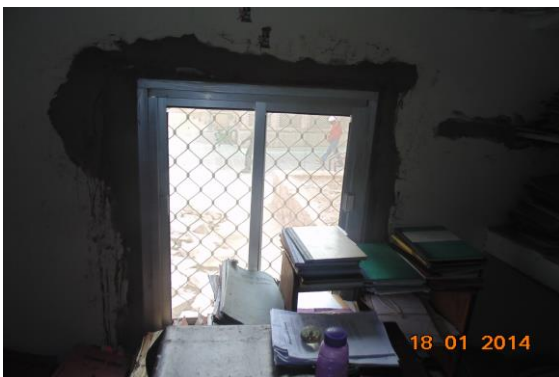
Photo 381

Peeling of Plaster on Wall No. 4 of Room No, 402, Part A of Police H.Q. First Floor, Part A

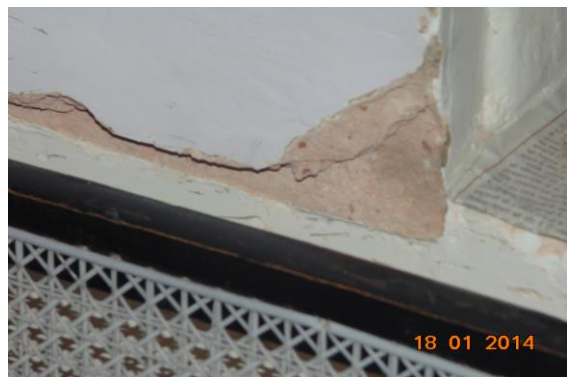
Photo 382

Peeling of Plaster on Wall No. 2 of Room No, 402, Part A of Police H.Q. First Floor, Part A

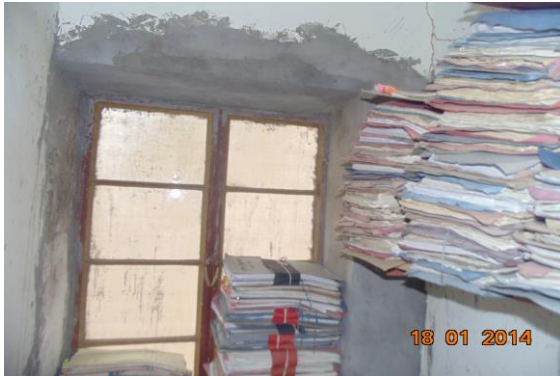
Photo 383

Peeling of Plaster on Wall No. 4 of Room No. 402, Part D of Police H.Q. First Floor, Part A

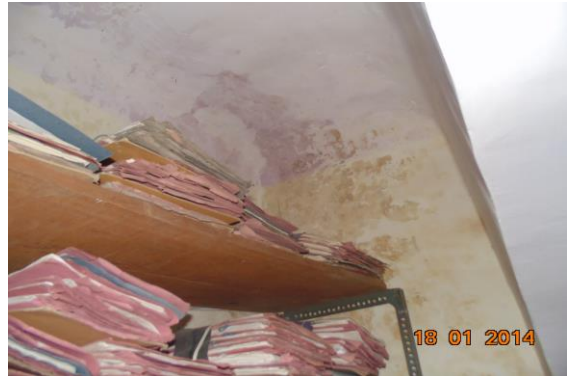
Photo 384

Dampness/Seepage on Wall No. 4 & Roof of Room No. 402, Part C of Police H.Q. First Floor, Part A

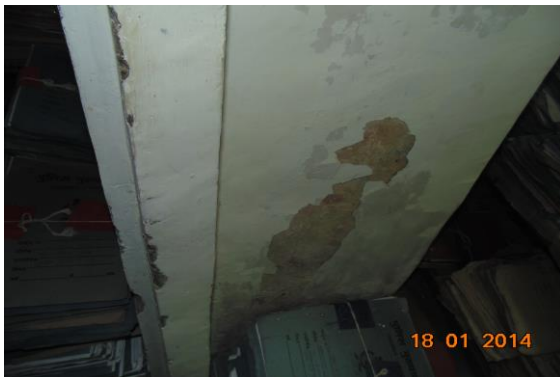
Photo 385

Peeling of Plaster on Wall No. 3 of Room No. 402, Part E of Police H.Q. First Floor, Part A

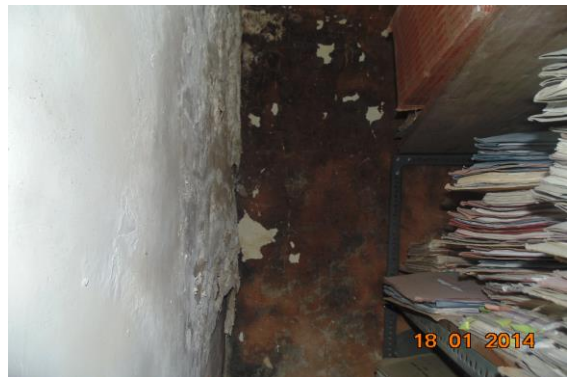
Photo 386

Peeling of Plaster on Wall No. 1 of Room No. 402, Part E of Police H.Q. First Floor, Part A

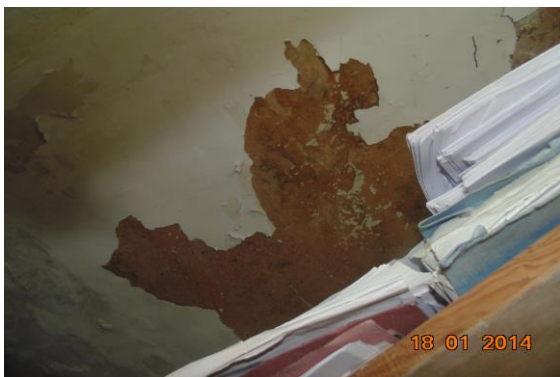
Photo 387

Peeling of Plaster on Roof of Room No. 402, Part E of Police H.Q. First Floor, Part A

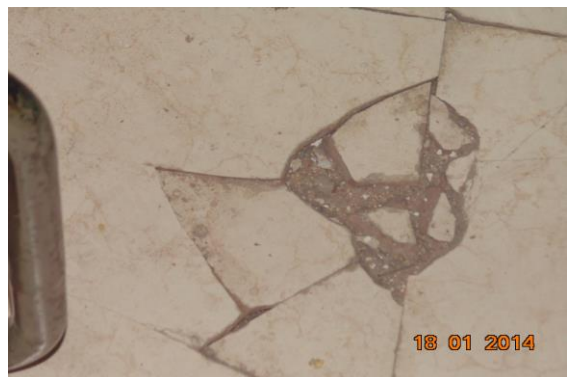
Photo 388

Damaged Portion on Floor of Room No. 402, Part D of Police H.Q. First Floor, Part A

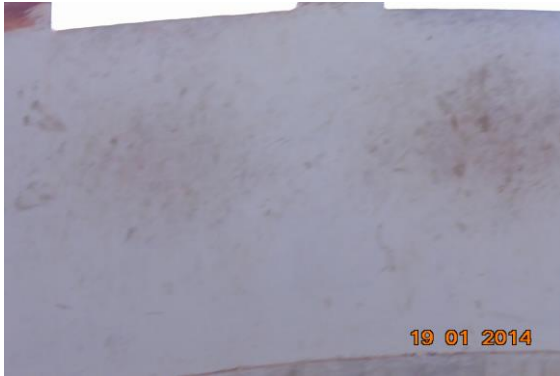
Photo 389

Dampness/Seepage on Wall No. 4 of Varanda of Police H.Q. First Floor, Part E

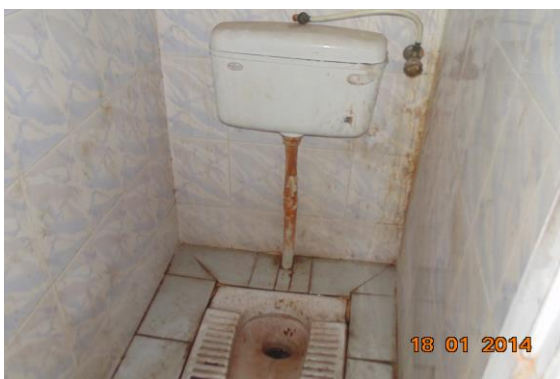
Photo 459

All wall & Floor of Toilet No. 5 of Police H.Q. First Floor, Part C Covered with Tiles

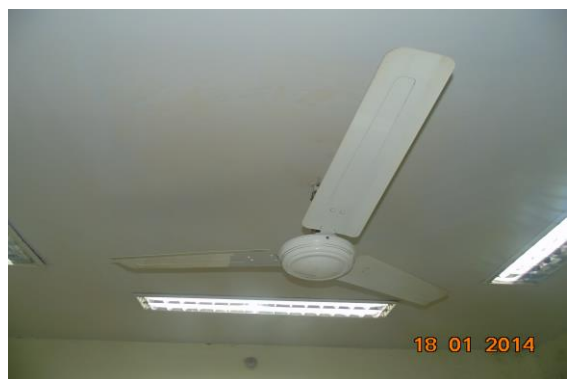
Photo 460

Roof of Room No. 309 of Police H.Q. First Floor, Part C Covered with Fall Ceiling

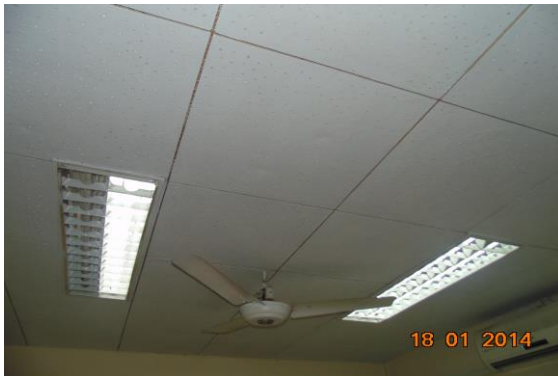
Photo 461

Roof of Room No. 310 of Police H.Q. First Floor, Part C Covered with Fall Ceiling

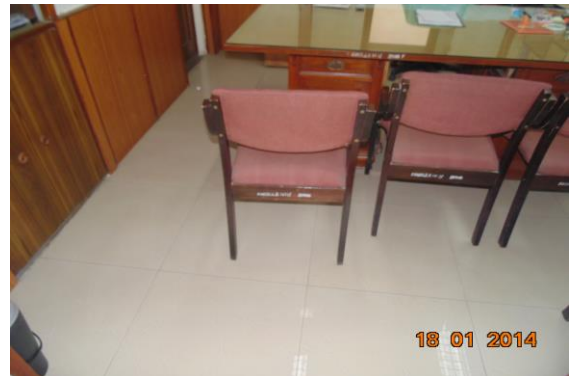
Photo 462

Floor of Room No. 310 of Police H.Q. First Floor, Part C Covered with Tiles

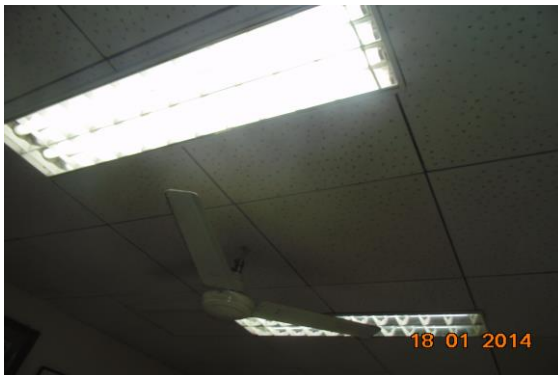
Photo 463

Roof of Room No. 311 of Police H.Q. First Floor, Part C Covered with Fall Ceiling

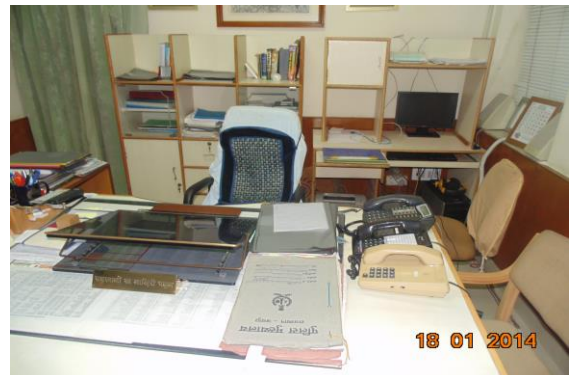
Photo 464

Bottom of Room No. 311 of Police H.Q. First Floor, Part C

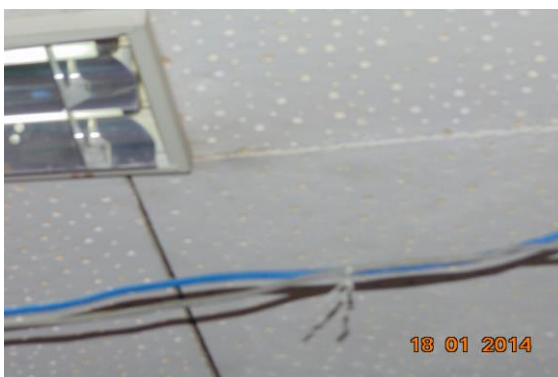
Photo 465

Roof of Room No. 312 of Police H.Q. First Floor, Part C Covered with Fall Ceiling

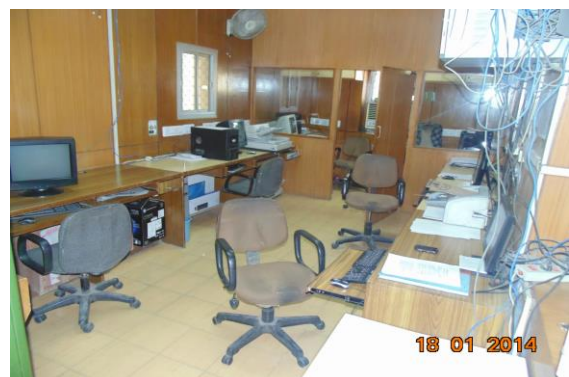
Photo 466

Wall No. 2 & 4 of Room No. 312 of Police H.Q. First Floor, Part C Covered with Wooden Work

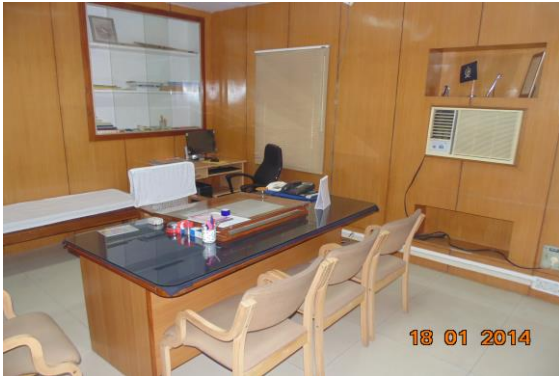
Photo 467

Wall No. 1 & 4 of Room No. 313 of Police H.Q. First Floor, Part C Covered with Wooden Work

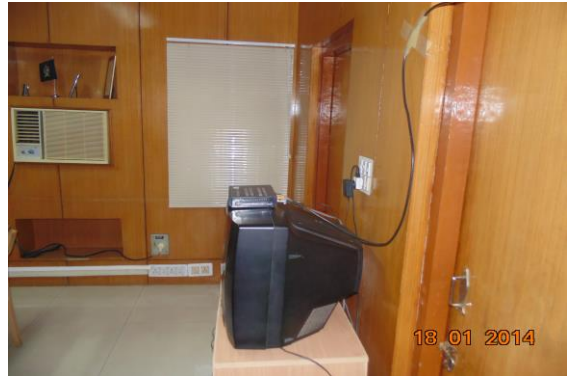
Photo 468

Wall No. 2 & 4 of Room No. 313 of Police H.Q. First Floor, Part C Covered with Wooden Work

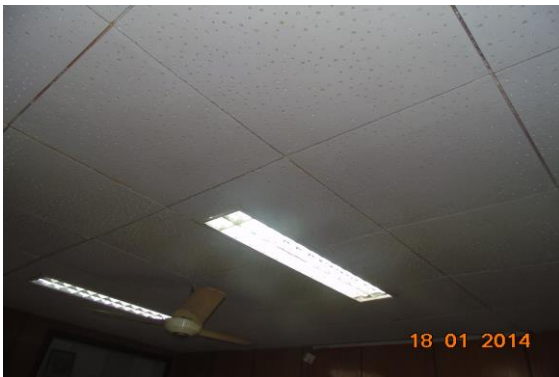
Photo 469

Roof of Room No. 313 of Police H.Q. First Floor, Part C Covered with Fall Ceiling

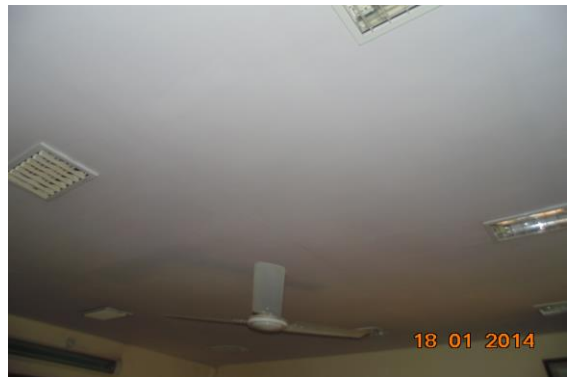
Photo 470

Roof of Room No. 314 of Police H.Q. First Floor, Part C Covered with Fall Ceiling

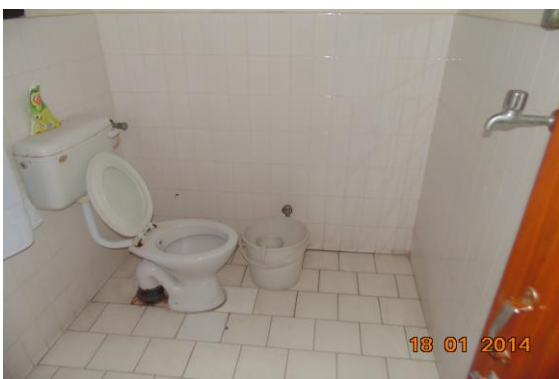
Photo 471

All wall of Toilet No. 5 of Police H.Q. First Floor, Part C Covered with Tiles

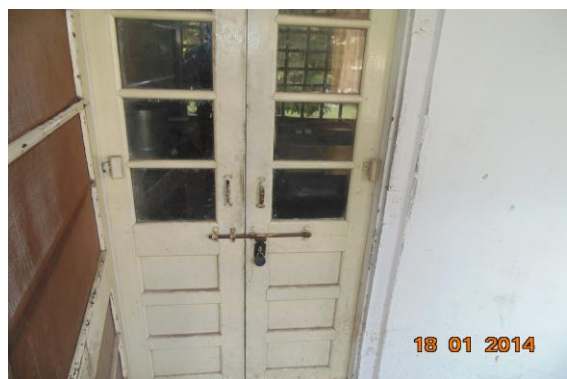
Photo 472

Room No. 315 of Police H.Q. First Floor, Part C Locked

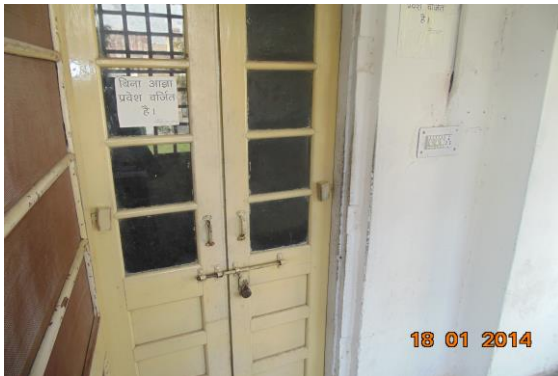
Photo 473
Room No. 316 of Police H.Q. First Floor, Part C

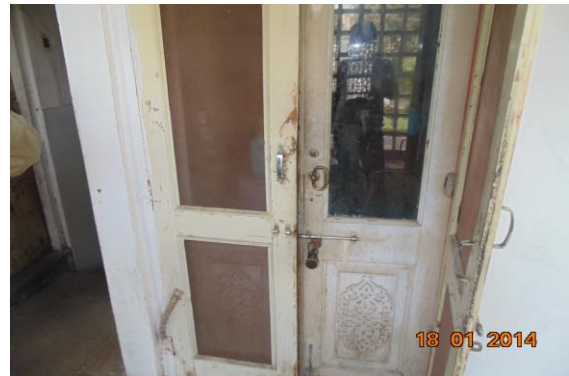
Photo 474
Room No. 317 of Police H.Q. First Floor, Part C

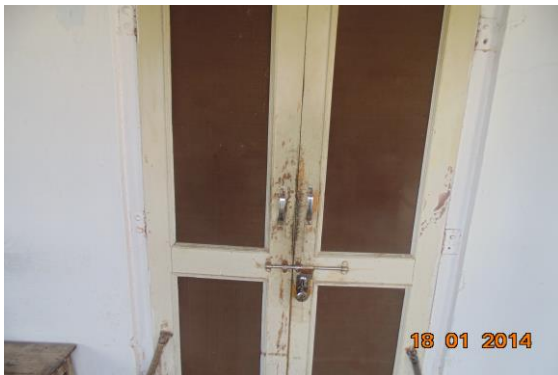
Photo 475
Room No. 318 of Police H.Q. First Floor, Part C

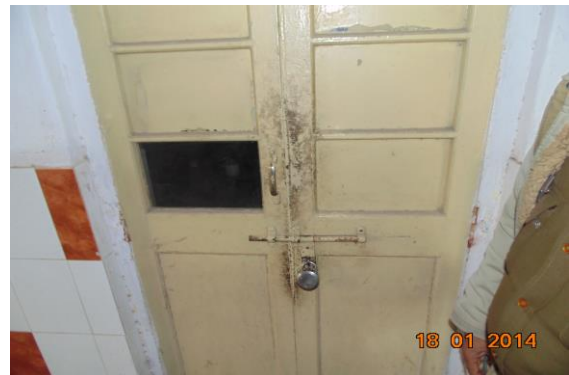
Photo 476
Store 1 of Police H.Q. First Floor, Part C Locked

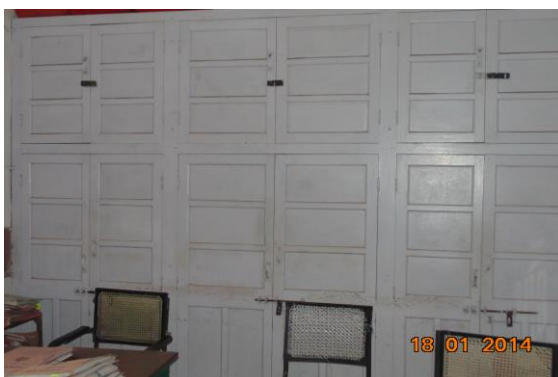
Photo 477
Room No. 323 of Police H.Q. First Floor, Part C Covered with Almirah

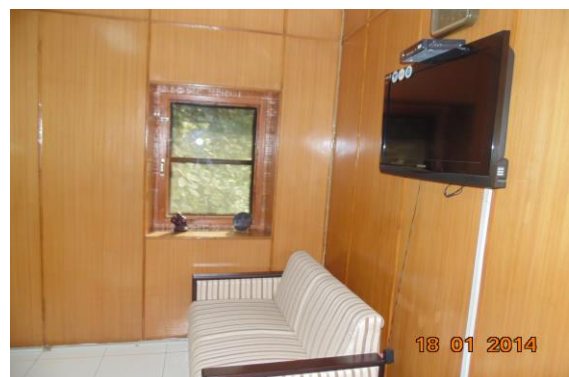
Photo 478
Wall No. 2 & 4 of Room No. 320 of Police H.Q. First Floor, Part C Covered with Wooden Work
