Pre Building Condition Survey Report

Name and Address of Structure :	Choti Chopar to Badi Chopar (UP Line)
---------------------------------	---------------------------------------

Name of the Project	Contract JMRC-UG1B “Design and Construction of Tunnel between Chandpole and Badi Chouper and reverse line by Shield TBM, Underground Metro Stations at Choti Chouper and Badi Chouper by Cut and Cover Methods on East West Corridor of Jaipur Metro Rail Corporation Limited .”	
Owner :

Shoping Complex - Shop No. 169-188
Tripolia Bazar
Jaipur
Unique ID: CC BC UP 0001

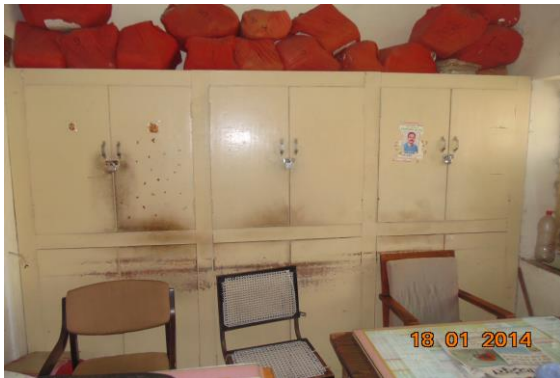
Photo 479

Wall No. 1 of Room No. 409 of Police H.Q. First Floor, Part A Covered with Almirah

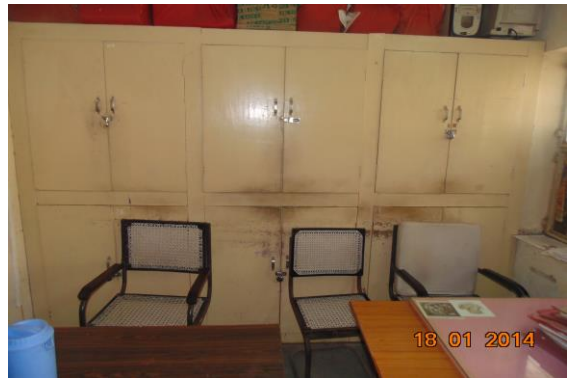
Photo 480

Wall No. 1 of Room No. 410 of Police H.Q. First Floor, Part A

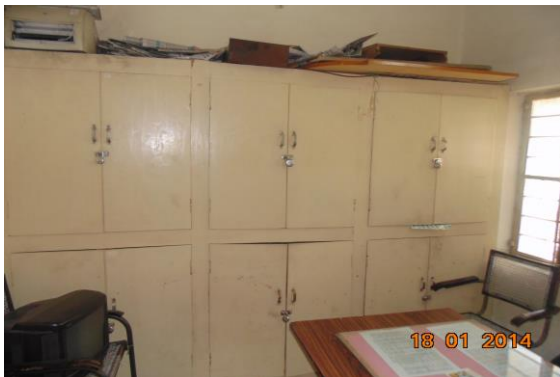
Photo 481

Wall No. 1 of Room No. 411 of Police H.Q. First Floor, Part A

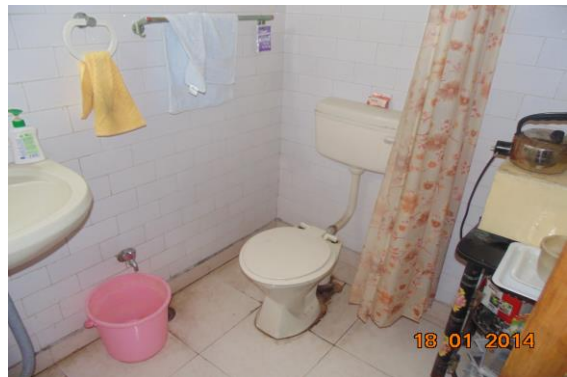
Photo 482

Wall No. 1 & 4 of Toilet No. 1 of Police H.Q. First Floor, Part A Covered With Tiles

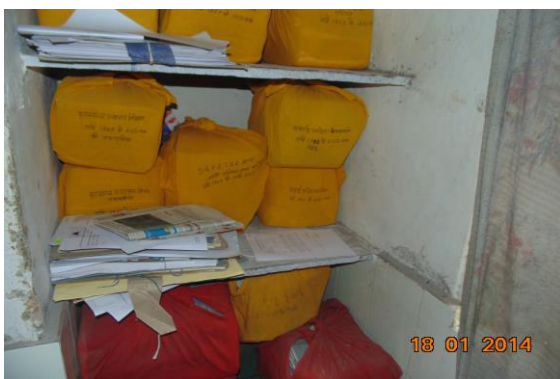
Photo 483

Wall No. 1 of Store 1 of Police H.Q. First Floor, Part A

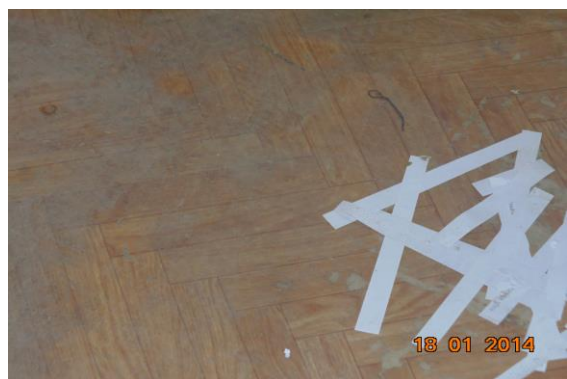
Photo 484

Floor of Room No. 396 of Police H.Q. First Floor, Part A

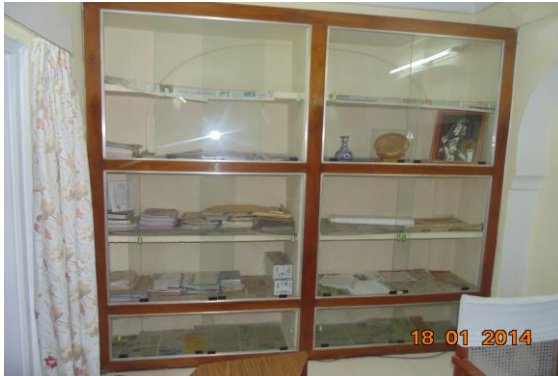
Photo 485

Wall No. 4 of Room No, 397 of Police H.Q. First Floor, Part A

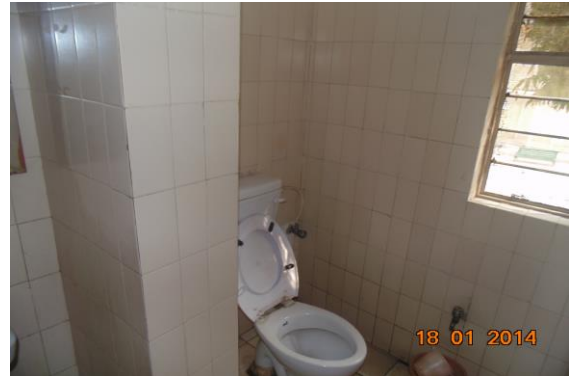
Photo 486

All wall & Floor of Toilet No. 3 of Police H.Q. First Floor, Part A

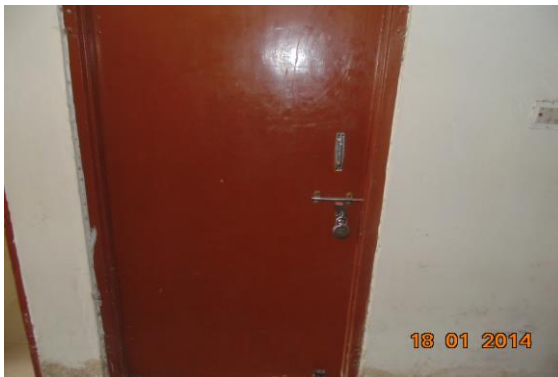
Photo 487

Room No, 430 of Police H.Q. First Floor, Part A

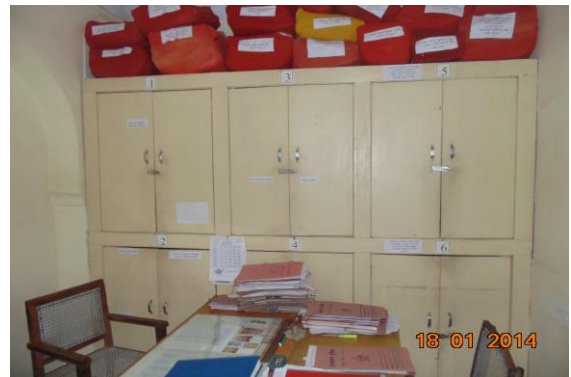
Photo 488

Wall No. 1 of Room No, 398 of Police H.Q. First Floor, Part A Covered with Almira

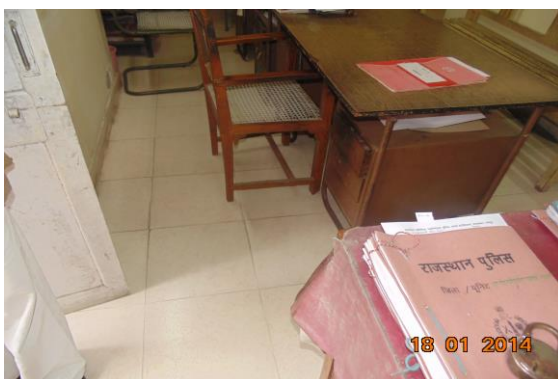
Photo 489

Floor of Room No, 398 A of Police H.Q. First Floor, Part A Covered with Tiles

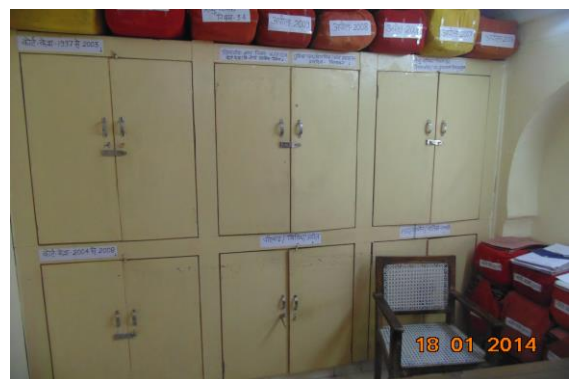
Photo 490

Wall No. 2 of Room No, 399 of Police H.Q. First Floor, Part A Covered with Tiles

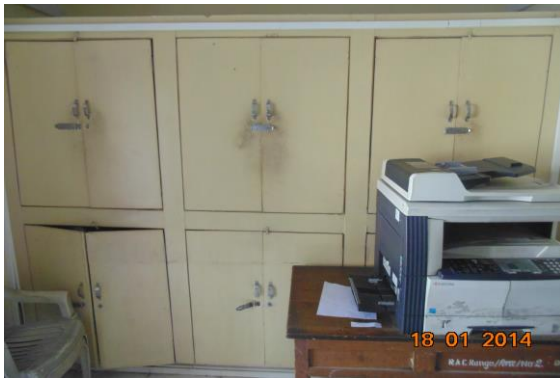
Photo 491

Wall No. 1 of Room No. 399 of Police H.Q. First Floor, Part A Covered with Tiles

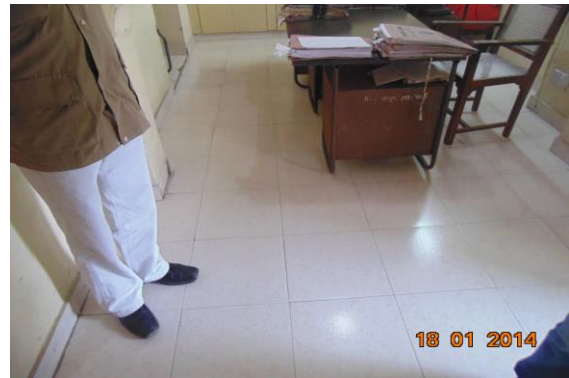
Photo 492

Floor of Room No. 399 of Police H.Q. First Floor, Part A Covered with Tiles

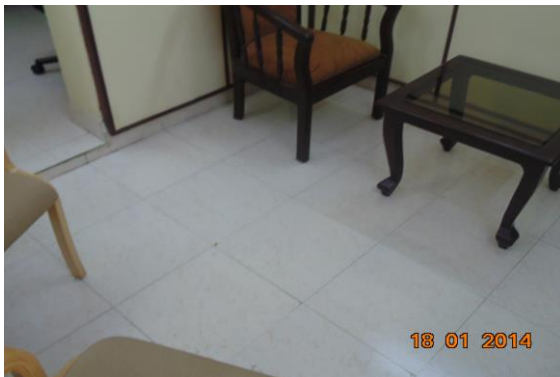
Photo 493

Floor of Room No. 400, Part B of Police H.Q. First Floor, Part A Covered with Tiles

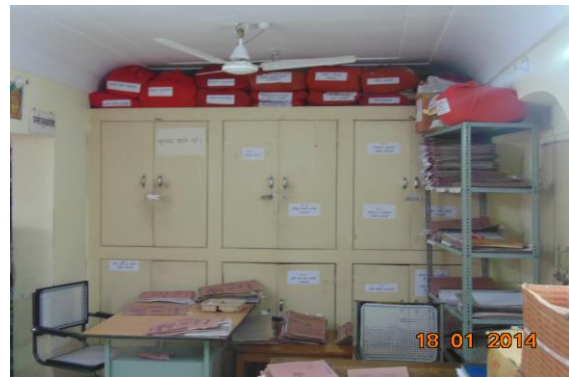
Photo 494

Wall No. 2 of Room No. 401 of Police H.Q. First Floor, Part A Covered with Almira

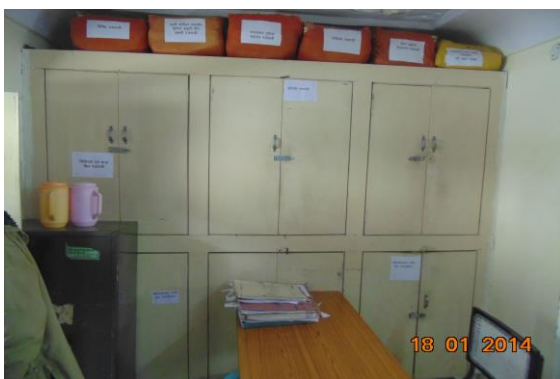
Photo 495

Wall No. 1 of Room No. 401 of Police H.Q. First Floor, Part A Covered with Almira

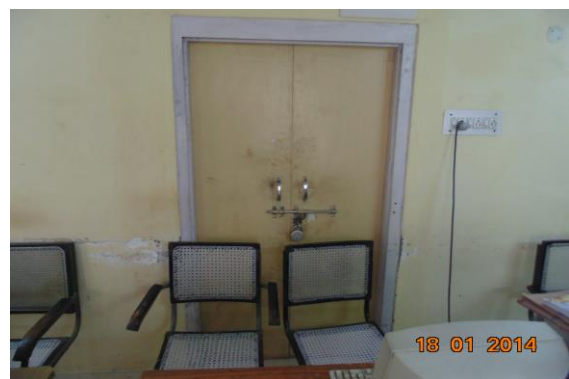
Photo 496

Room No. 401, Part B of Police H.Q. First Floor, Part A Locked

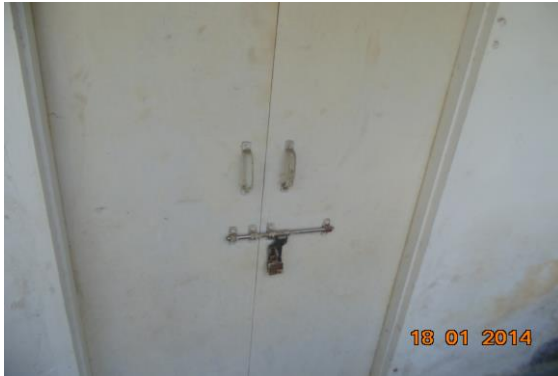
Photo 497
Store 2 of Police H.Q. First Floor, Part A

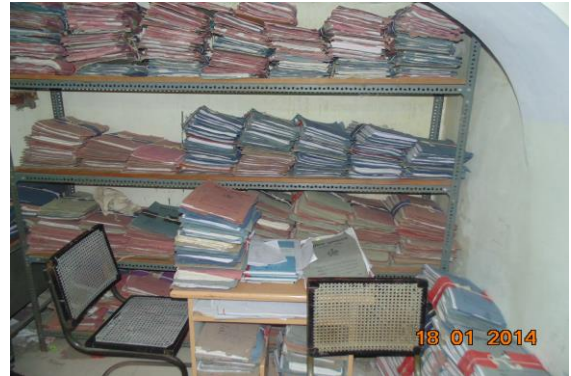
Photo 498
Wall No. 4 of Room No, 402, Part C of Police H.Q. First Floor, Part A
Covered with Files

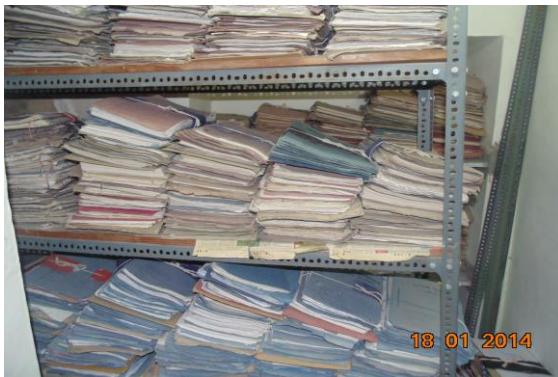
Photo 499
All wall of Room No, 402, Part E of Police H.Q. First Floor, Part A
Covered with Files

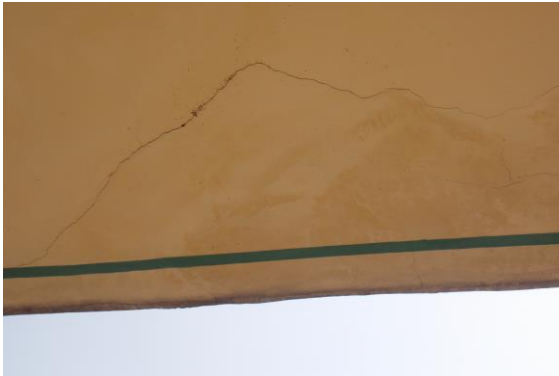
Photo 7

Inclined Crack on Shade of Tomb, Isarlat
Approx. Width = 0.6mm, Approx. Length = 2m.
Distance from Tomb Outer Wall = 1.2m, Height from Floor = 3.8m.

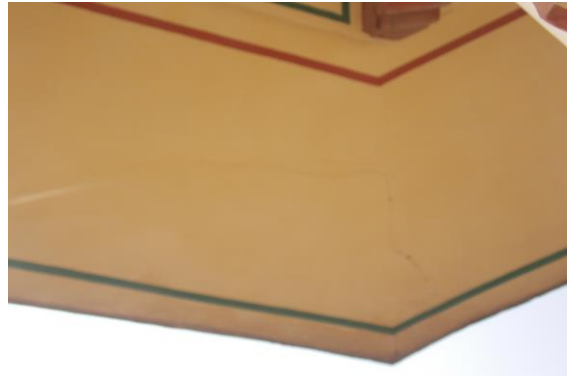
Photo 8

Inclined Crack on Shade of Tomb, Isarlat
Approx. Width = 0.35mm, Approx. Length = 2m.
Distance from Tomb Outer Wall = 1.2m, Height from Floor = 3.8m.

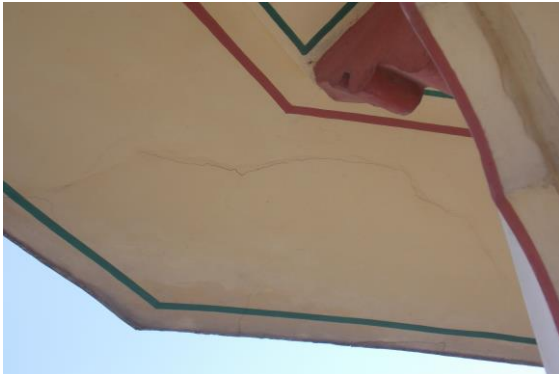
Photo 9

Inclined Crack on Shade of Tomb, Isarlat
Approx. Width = 0.35mm, Approx. Length = 1.5m.
Distance from Tomb Outer Wall = 1.2m, Height from Floor = 3.8m.

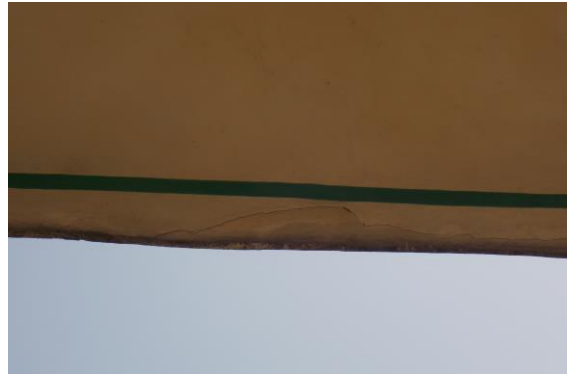
Photo 10

Inclined Crack on Tomb, Isarlat
Approx. Width = 0.35mm, Approx. Length = 1.3m.
Distance from Tomb Outer Wall = 1.2m, Height from Floor = 3.8m.

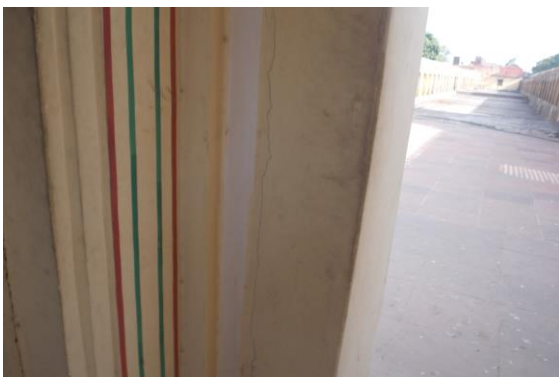
Photo 11

Vertical Crack on Rightside of Main Entrance, Isarlat
Approx. Width = 0.6mm, Approx. Length = 1.75m.
Distance from Left side of Outer Wall = 0.21m, Height Floor = 0m.

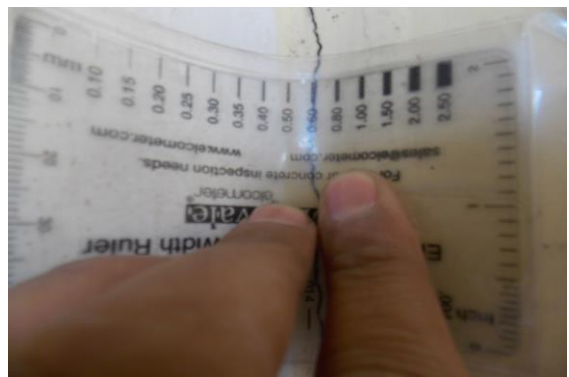
Photo 11A

Vertical Crack on Rightside of Main Entrance, Isarlat
Approx. Width = 0.6mm, Approx. Length = 1.75m.
Distance Left side of Outer Wall = 0.21m, Height Floor = 0m.

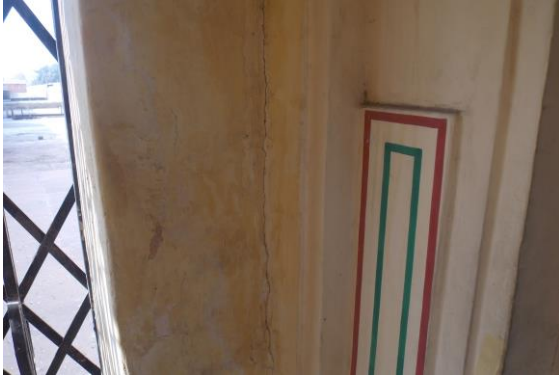
Photo 12

Vertical Crack on Leftside of Main Entrance, Isarlat
Approx. Width = 0.4mm, Approx. Length = 1.35m.
Distance Left side of Outer Wall = 0.24m, Height Floor = 0.3m.

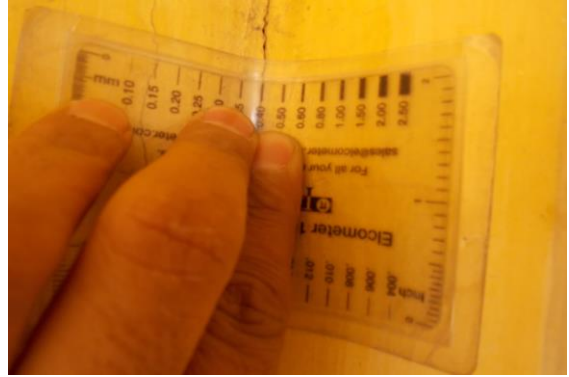
Photo 12A

Vertical Crack on Leftside of Main Entrance, Isarlat
Approx. Width = 0.4mm, Approx. Length = 1.35m.
Distance Left side of Outer Wall = 0.24m, Height Floor = 0.3m.

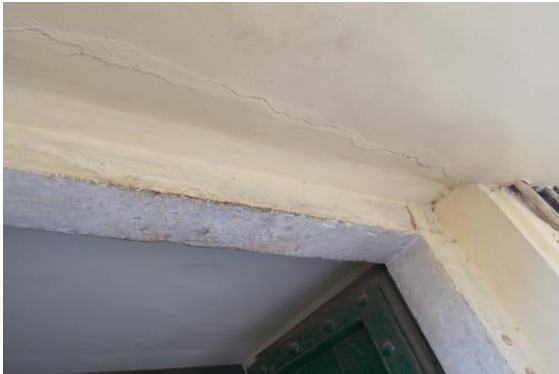
Photo 13

Inclined Crack on Roof of Main Entrance, Isarlat
Approx. Width = 0.8mm, Approx. Length = 4m.
Distance from Front Wall of Door = 0.37m, Height Floor = 1.73m.

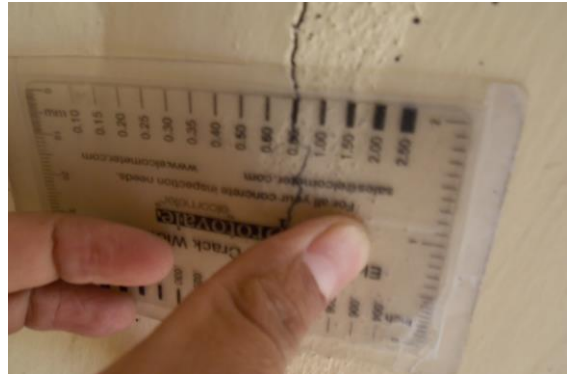
Photo 13A

Inclined Crack on Roof of Main Entrance, Isarlat
Approx. Width = 0.8mm, Approx. Length = 4m.
Distance from Front Wall of Door = 0.37m, Height Floor = 1.73m.

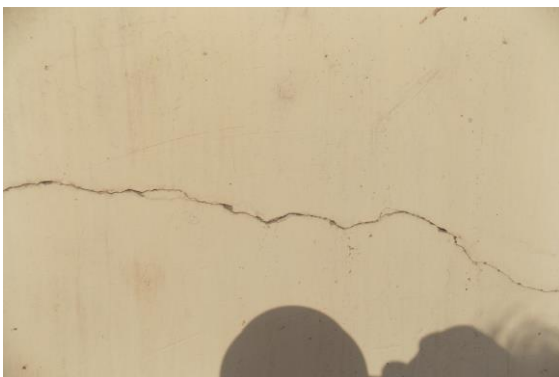
Photo 14

Inclined Crack on Wall No. 1 & 2 of Main Entrance, Isarlat
Approx. Width = 0.3mm, Approx. Length = 1m.
Distance from Wall No. 1 & 2 = 0m, Height from Floor = 2.5m.

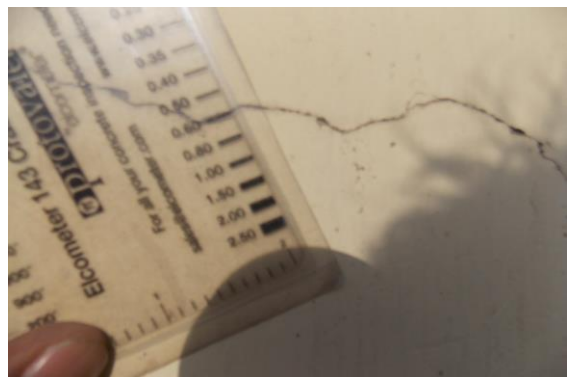
Photo 14A

Inclined Crack on Wall No. 1 & 2 of Main Entrance, Isarlat
Approx. Width = 0.3mm, Approx. Length = 1m.
Distance from Wall No. 1 & 2 = 0m, Height from Floor = 2.5m.

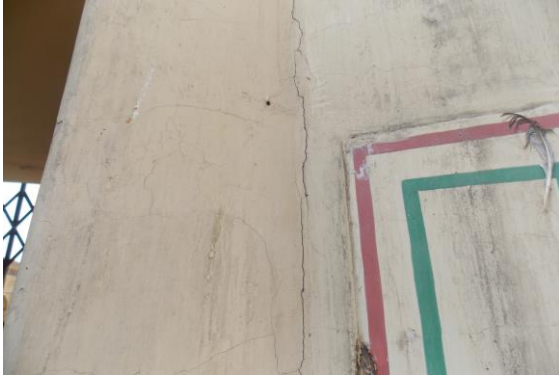
Photo 15

Vertical Crack on Wall No. 2 of Rightside of Main Entrance, Isarlat
Approx. Width = 0.6mm, Approx. Length = 2.2m.
Distance from Wall No. 1 & 2 = 0m, Height from Floor = 0.43m.

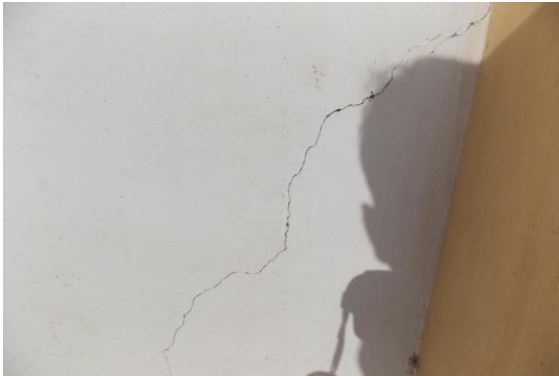
Photo 16

Inclined Crack on Wall No. 3 of , First Floor, Isarlat
Approx. Width = 0.6mm, Approx. Length = 2.2m.
Distance from Wall No. 2 = 3m, Height from Floor = 0m.

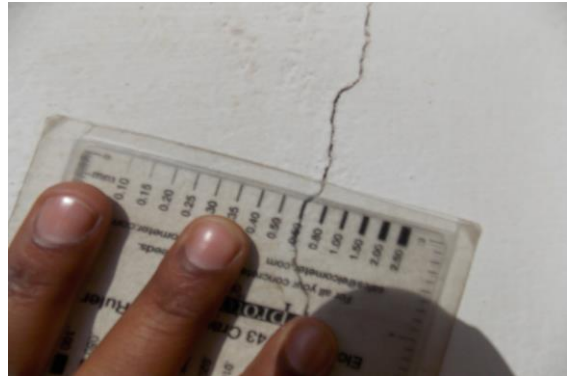
Photo 16A

Inclined Crack on Wall No. 3 of , First Floor, Isarlat
Approx. Width = 0.6mm, Approx. Length = 2.2m.
Distance from Wall No. 2 = 3m, Height from Floor = 0m.

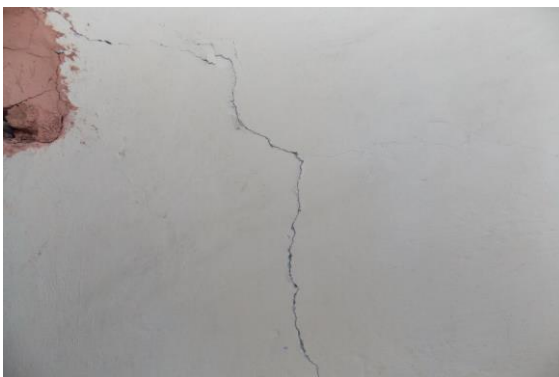
Photo 17

Inclined Crack on Stair GF to FF, Isarlat
Approx. Width = 0.35mm, Approx. Length = 4m.
Distance from Wall No. 3 = 2.5m, Height from Floor = 0m.

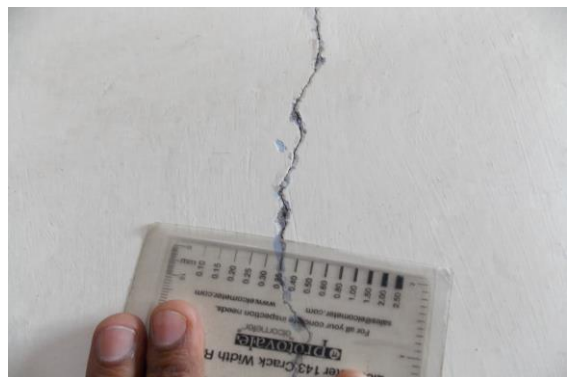
Photo 17A

Inclined Crack on Stair GF to FF, Isarlat
Approx. Width = 0.35mm, Approx. Length = 4m.
Distance from Wall No. 3 = 2.5m, Height from Floor = 0m.

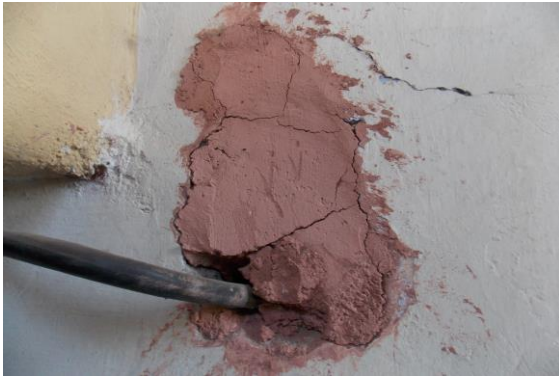
Photo 18

Inclined Crack on Stair GF to FF, Isarlat
Approx. Width = 0.35mm, Approx. Length = 4m.
Distance from Wall No. 3 = 2.5m, Height from Floor = 0m.

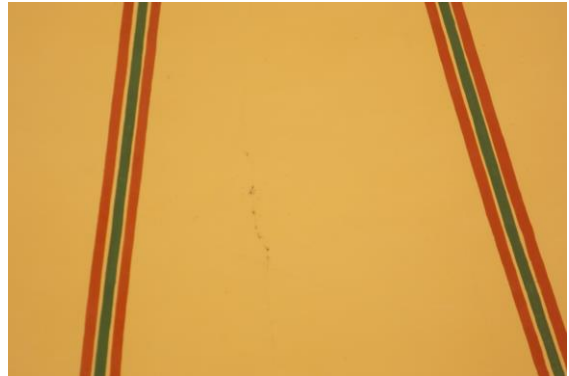
Photo 19

Peeling of Plaster on Roof of Tomb of Isarlat

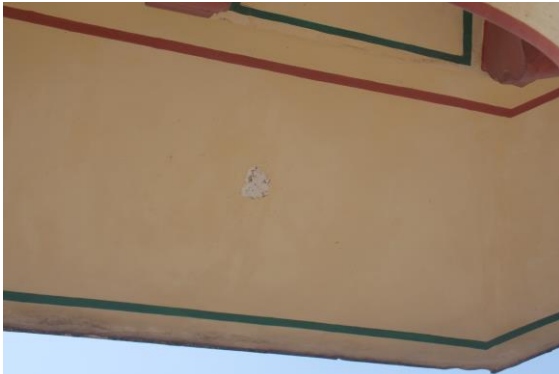
Photo 20

Peeling of Plaster on Shade of Tomb of Isarlat

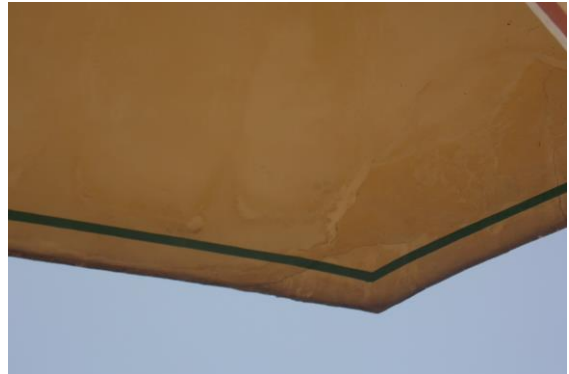
Photo 21

Plaster Crack on Shade of Tomb of Isarlat

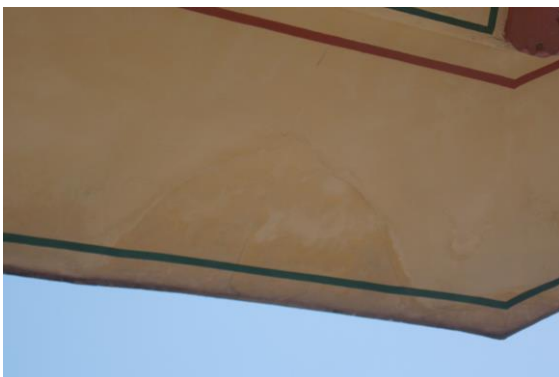
Photo 22

Plaster Crack on Shade of Tomb of Isarlat

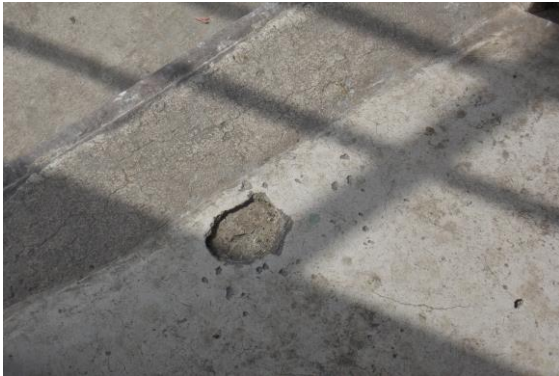
Photo 24
Peeling of Plaster on Floor of Tomb of Isarlat

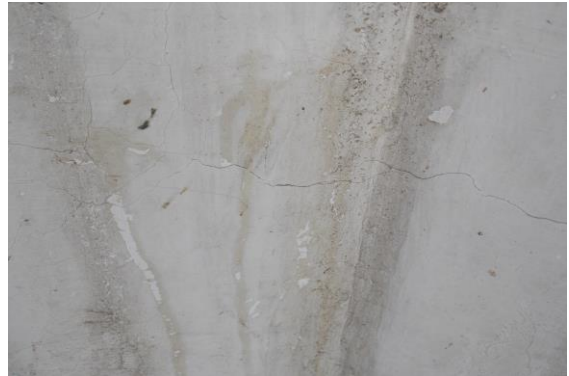
Photo 25
Plaster Crack on Wall No. 2 of Stair of Isarlat

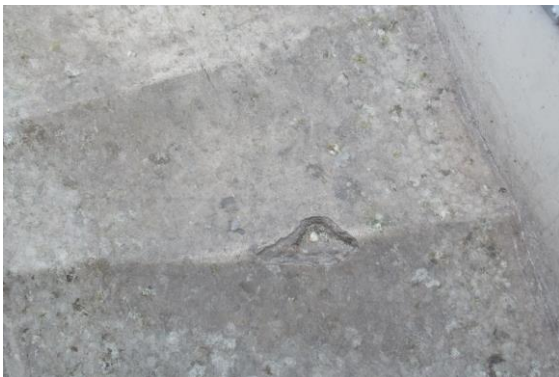
Photo 26
Peeling of Plaster on Stair Steps of Isarlat

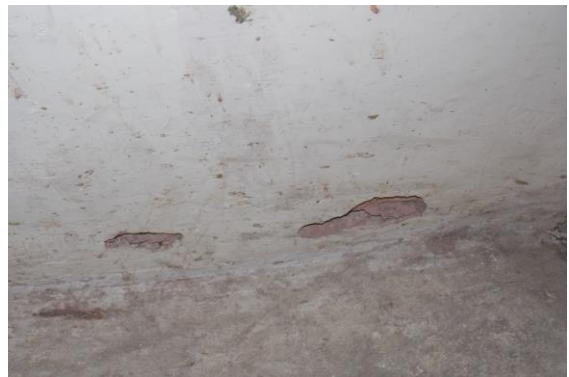
Photo 27
Peeling of Plaster on Wall No. 2 of Stair of Isarlat

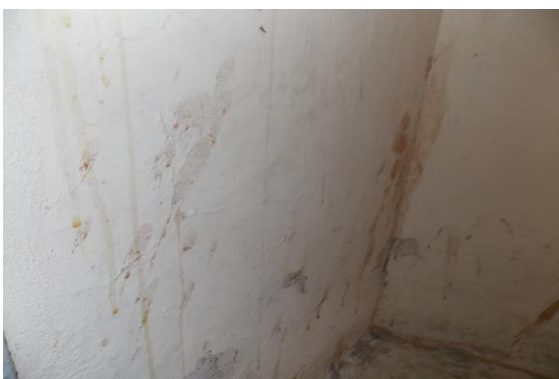
Photo 28
Peeling of Plaster on Wall No. 2 of Stair of Isarlat

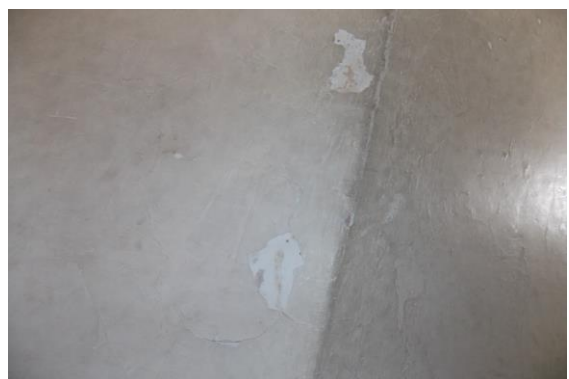
Photo 29
Peeling of Plaster on Wall No. 2 of Stair of Isarlat

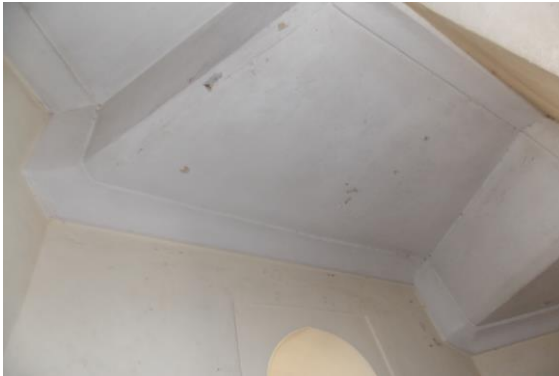
Photo 30
Peeling of Plaster on Roof of Stair of Isarlat

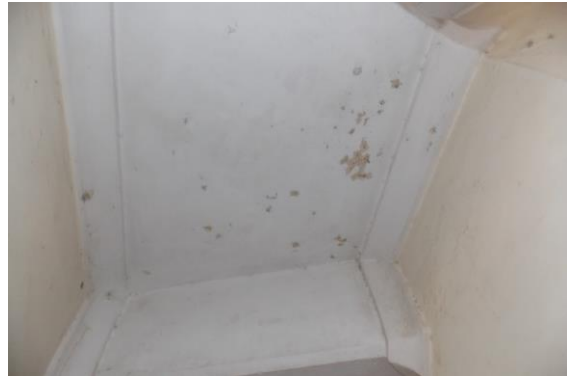
Photo 31
Peeling of Plaster on Roof of Stair of Isarlat

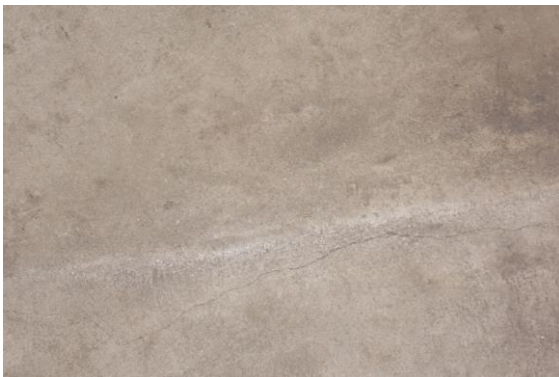
Photo 32
Plaster Crack on Stair Steps of Isarlat

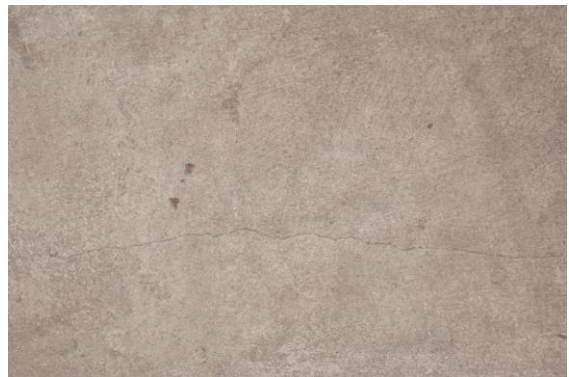
Photo 33
Plaster Crack on Stair Steps of Isarlat

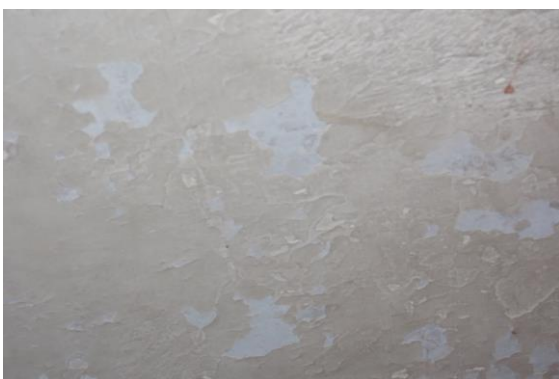
Photo 34
Peeling of Plaster on Wall No. 2 of Stair of Isarlat

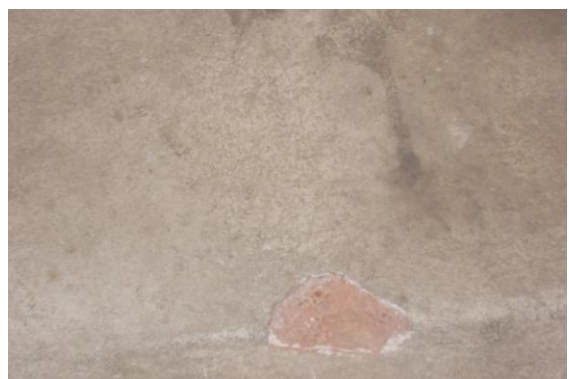
Photo 35
Peeling of Plaster on Stair Steps of Isarlat

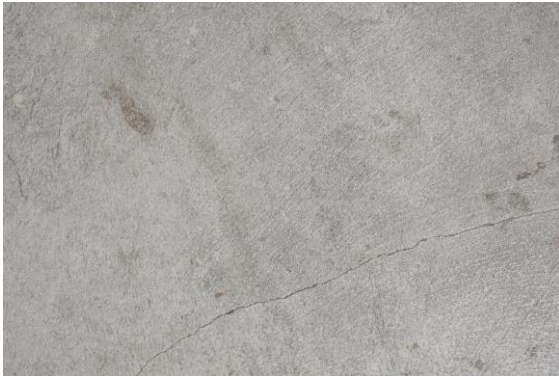
Photo 36
Plaster Crack on Stair Steps of Isarlat

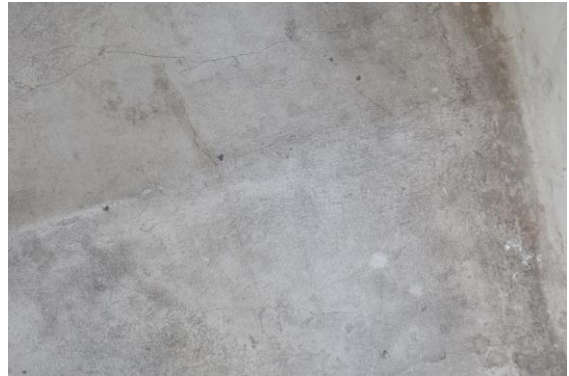
Photo 37
Plaster Crack on Stair Steps of Isarlat

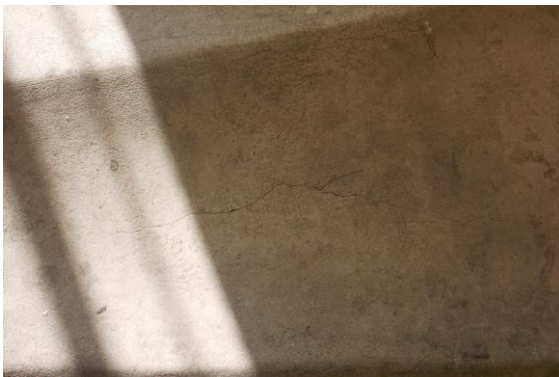
Photo 38
Plaster Crack on Stair Steps of Isarlat

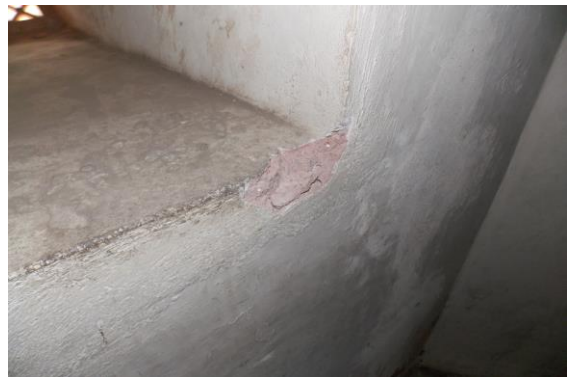
Photo 39
Peeling of Plaster on Wall No. 2 of Stair of Isarlat

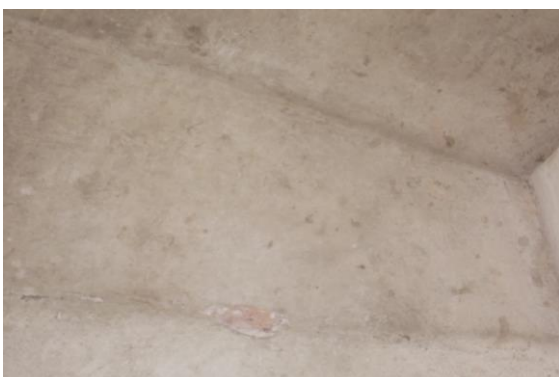
Photo 40
Peeling of Plaster on Stair Steps of Isarlat

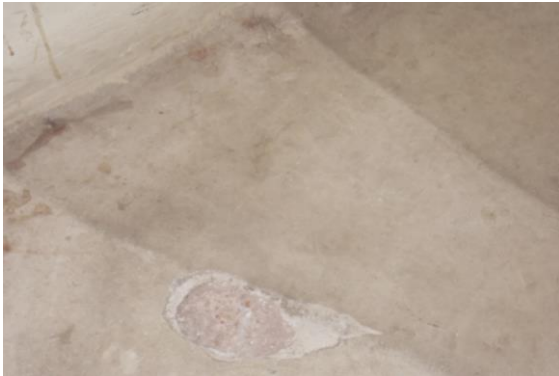
Photo 42
Peeling of Plaster on Stair Steps of Isarlat

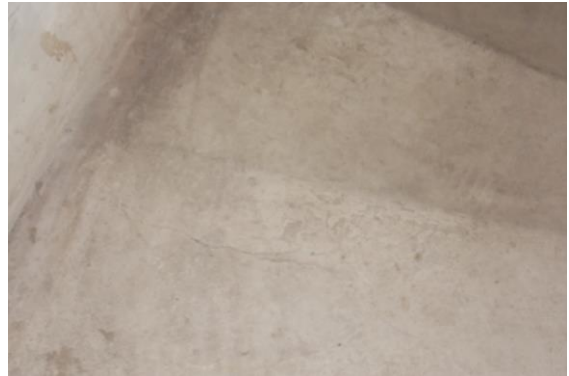
Photo 43
Plaster Crack on Stair Steps of Isarlat

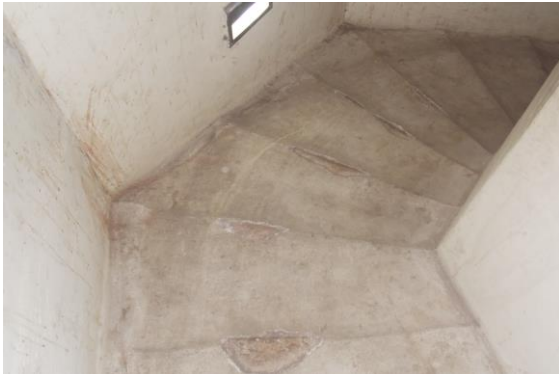
Photo 44
Plaster Crack on Stair Steps of Isarlat

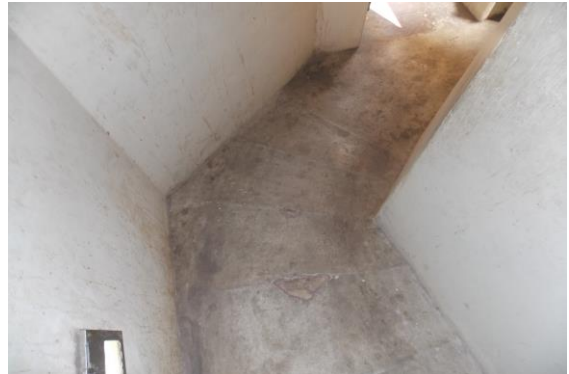
Photo 45
Peeling of Plaster on Stair Steps of Isarlat

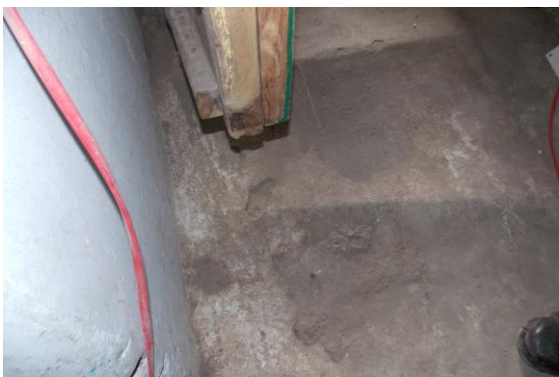
Photo 46
Peeling of Plaster on Stair FF to GF of Isarlat

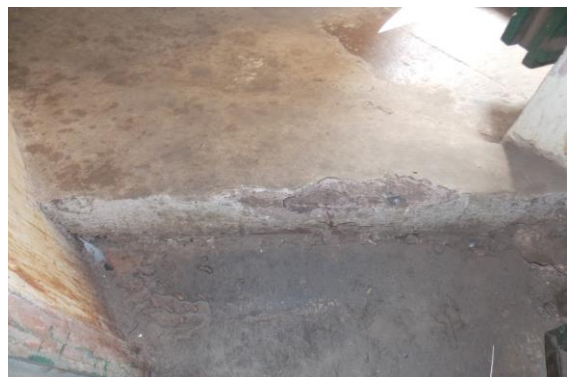
Photo 47
Peeling of Plaster on Stair FF to GF of Isarlat

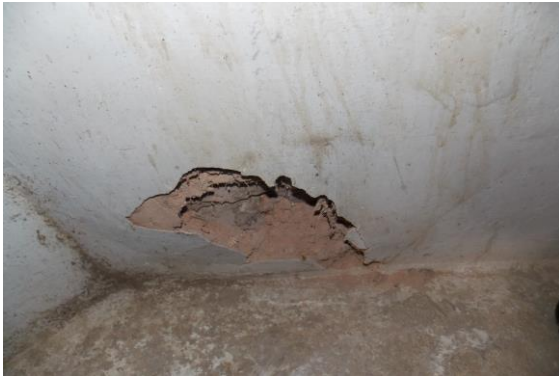
Photo 48

Peeling of Plaster on Wall No. 1 of Stair FF to GF of Isarlat

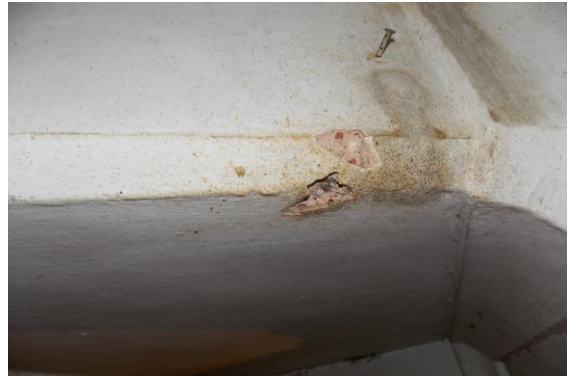
Photo 49

Peeling of Plaster on Roof of Stair FF to GF of Isarlat

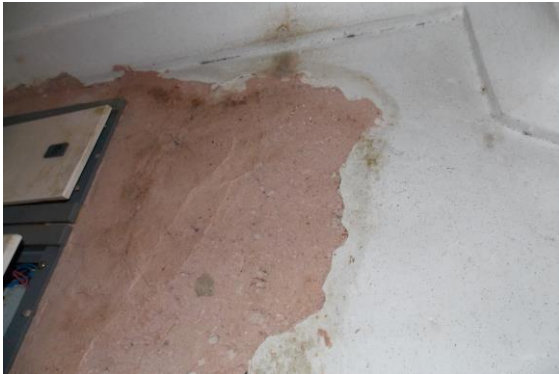
Photo 50

Peeling of Plaster on Wall No. 1 of Stair FF to GF of Isarlat

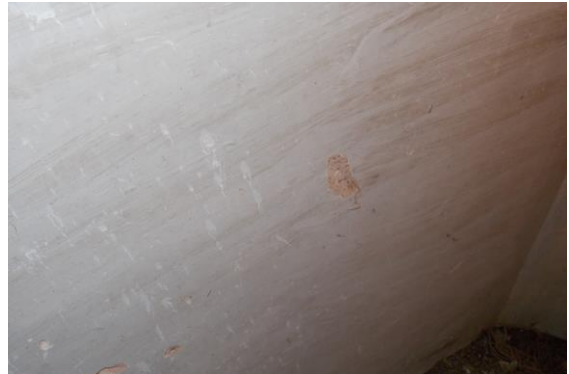
Photo 51

Peeling of Plaster on Wall No. 1 of Stair FF to GF of Isarlat

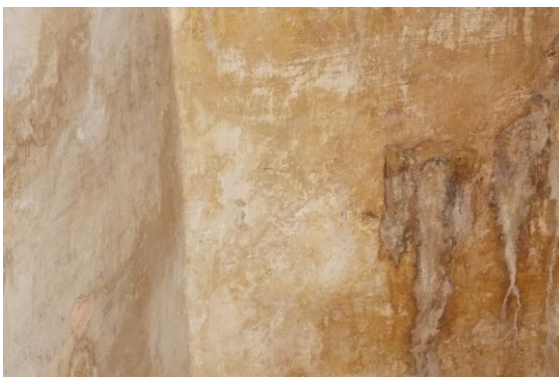
Photo 52

Dampness/Seepage on Wall No. 1 of Stair FF to GF of Isarlat

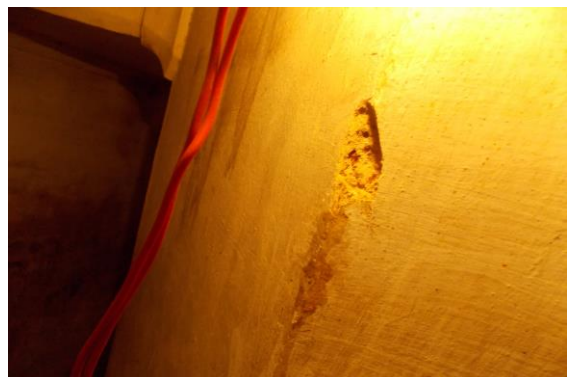
Photo 53

Peeling of Plaster on Wall No. 2 of Stair FF to GF of Isarlat

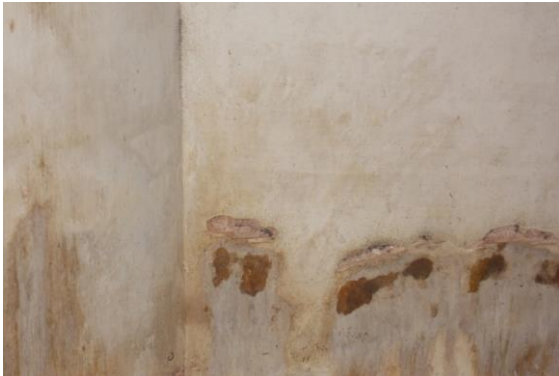
Photo 54

Peeling of Plaster on Wall No. 1 of Stair FF to GF of Isarlat

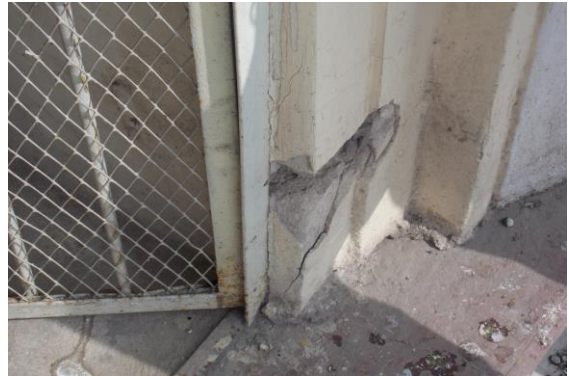
Photo 55

Peeling of Plaster on Outer Wall of Inner Circle of Balcony-1 of Isarlat

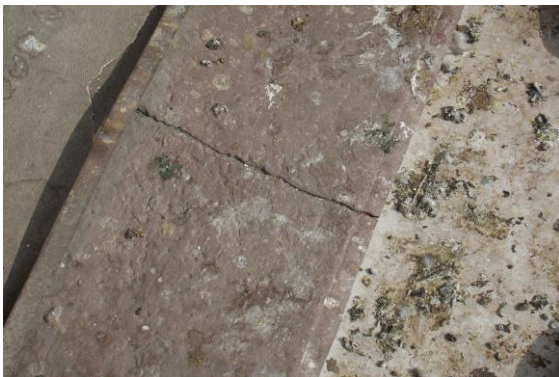
Photo 56

Damaged Portion on Floor of Gate of Balcony-1 of Isarlat

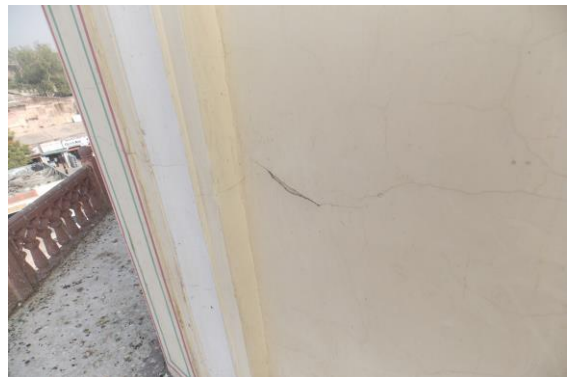
Photo 57

Plaster Crack on Outer Wall of Inner Circle of Balcony-1 of Isarlat

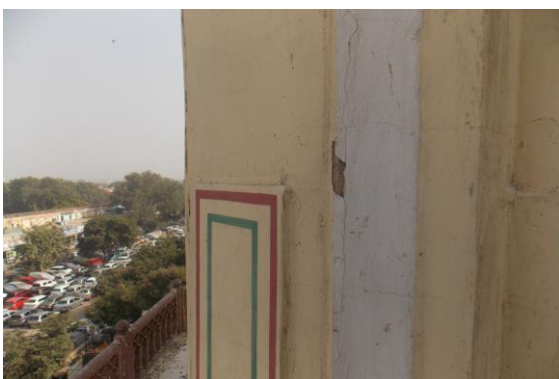
Photo 58

Peeling of Plaster on Outer Wall of Inner Circle of Balcony-1 of Isarlat

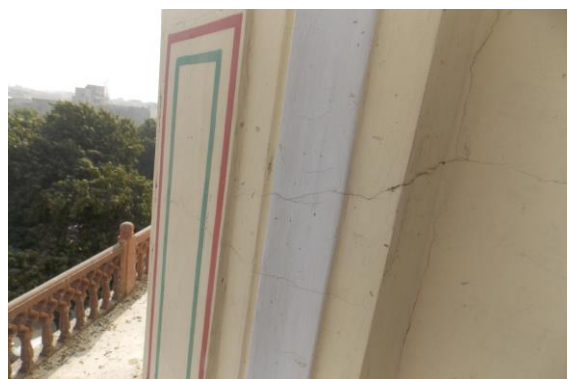
Photo 59

Plaster Crack on Outer Wall of Inner Circle of Balcony-2 of Isarlat

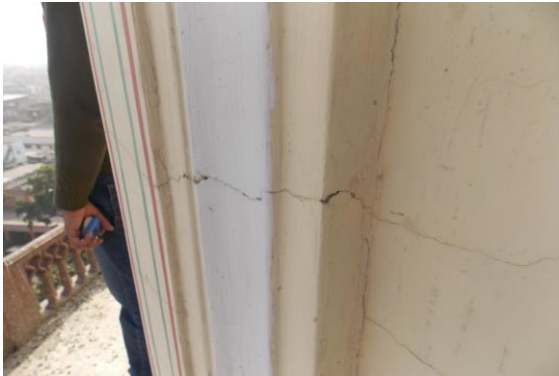
Photo 60

Plaster Crack on Outer Wall of Inner Circle of Balcony-2 of Isarlat

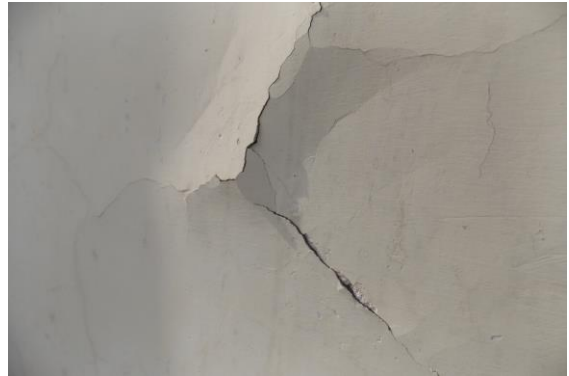
Photo 61

Peeling of Plaster on Outer Wall of Inner Circle of Balcony-2 of Isarlat

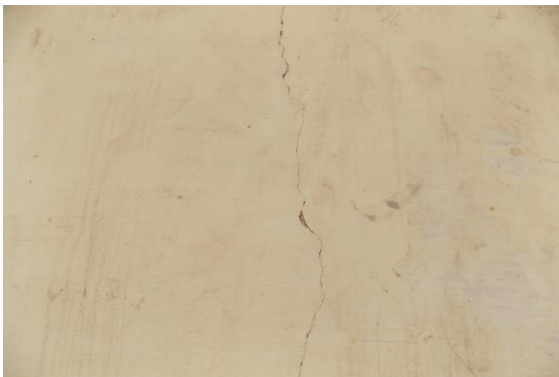
Photo 62

Plaster Crack on Wall No. 1 & 2 of Main Entrance of Isarlat

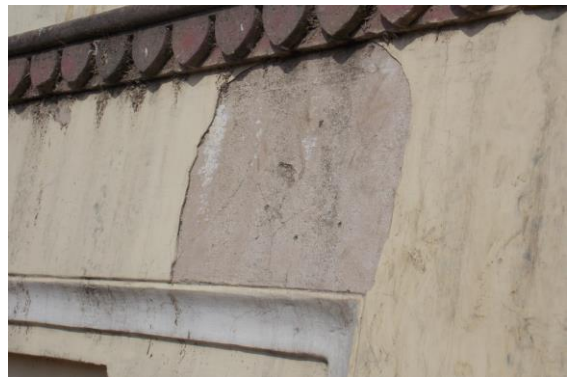
Photo 63

Peeling of Plaster on Wall No. 8 of Main Entrance of Isarlat

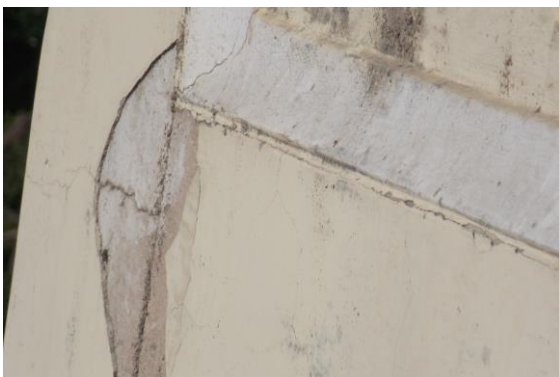
Photo 64

Peeling of Plaster on Wall No. 8 of Main Entrance of Isarlat

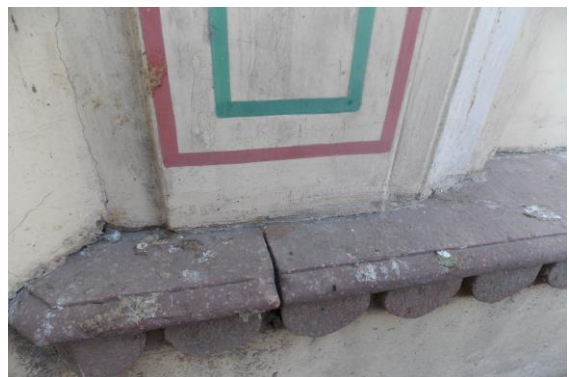
Photo 65

Damaged Portion on Rightside of Gate of Isarlat

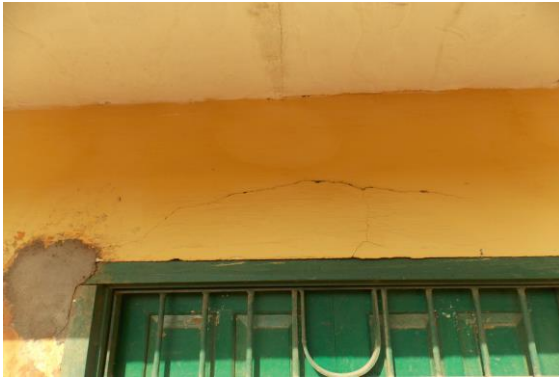
Photo 66
Peeling of Plaster on Wall No. 3 of First Floor, Isarlat

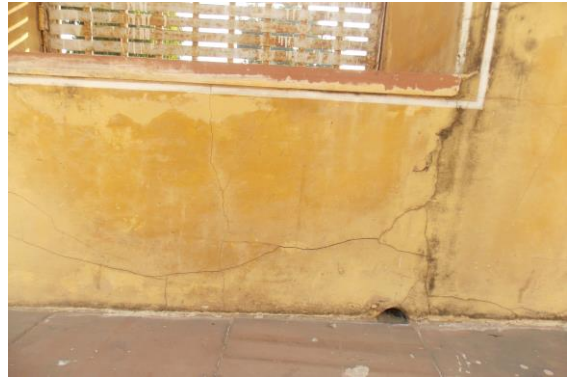
Photo 67
Peeling of Plaster on Wall No. 4 of First Floor, Isarlat

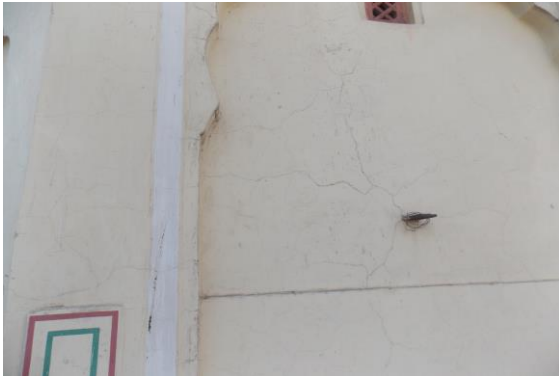
Photo 68
Plaster Crack on Wall No. 4, 5 & 6 of First Floor, Isarlat

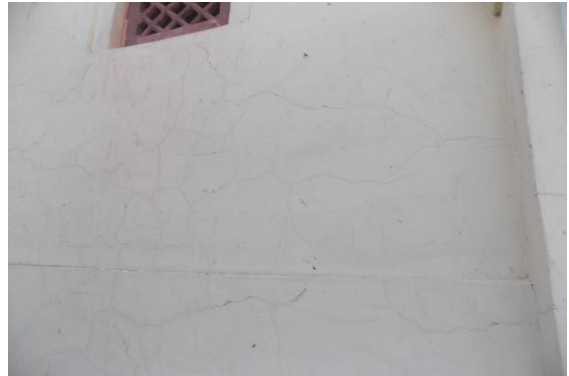
Photo 69
Plaster Crack on Wall No. 4, 5 & 6 of First Floor, Isarlat

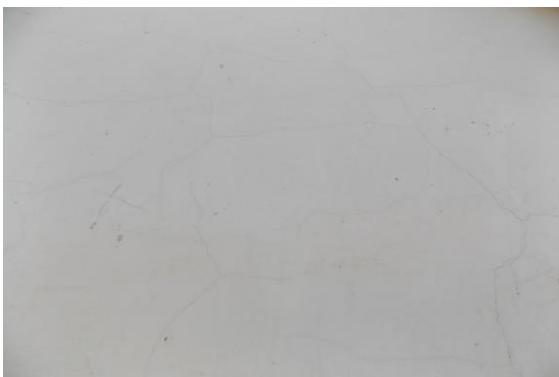
Photo 70
Plaster Crack on Wall No. 4, 5 & 6 of First Floor, Isarlat

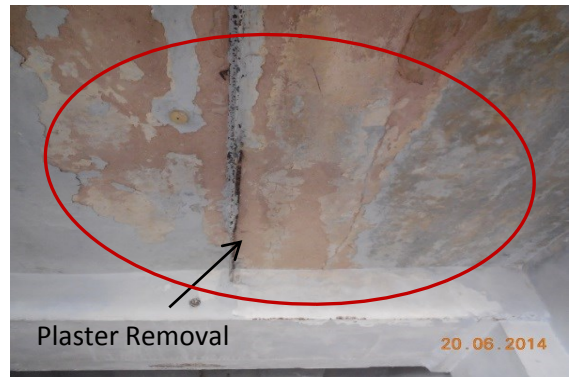
Photo 2

Plaster Removal on Roof of Shop No. 52, Ground Floor

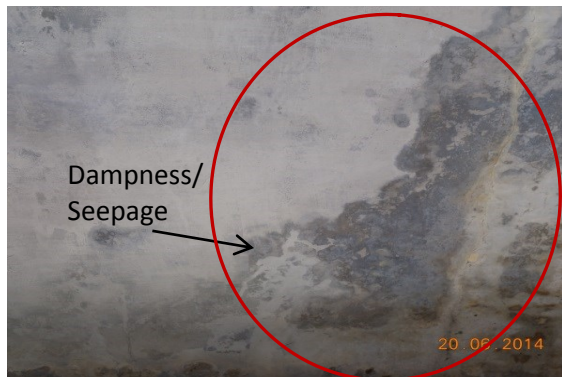
Photo 3

Dampness/ Seepage on Roof of Shop No. 52, Ground Floor

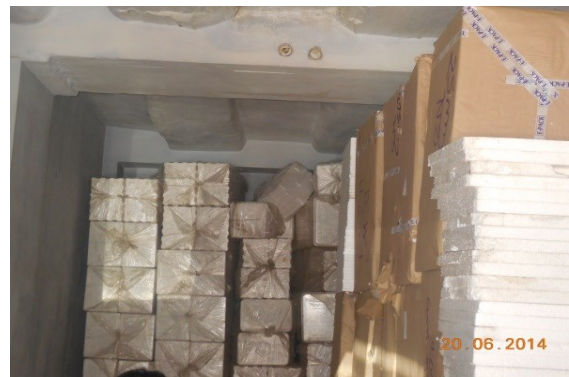
Photo 4

Covered with Materials, Wall No. 2 & 4 of Shop No. 52, Ground Floor

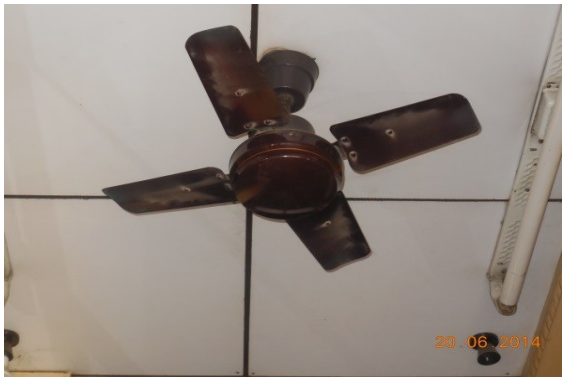
Photo 3

Covered with Wooden Ceiling, Roof of Shop No. 92A, Ground Floor

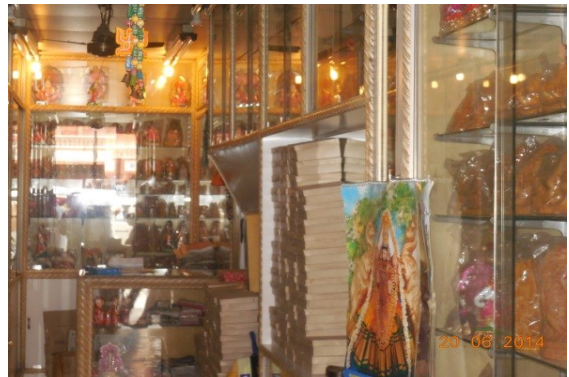
Photo 4

Covered with Materials, Wall No. 2 & 4 of Shop No. 92A, Ground Floor

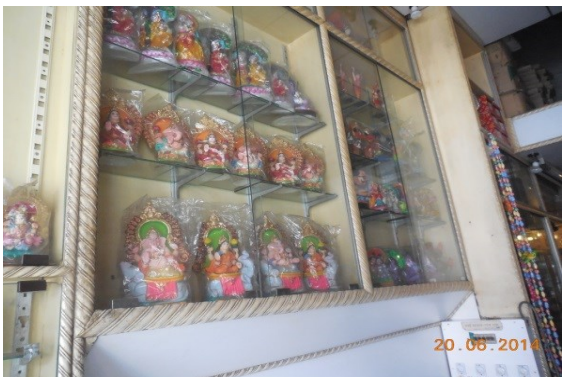
Photo 5

Covered with Materials, Wall No. 1 of Shop No. 92A, Ground Floor

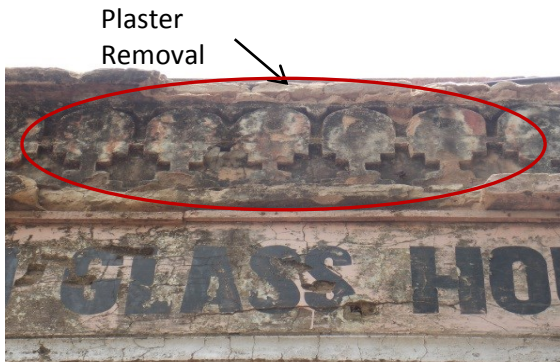
Photo 1

Plaster Removal of Outer Wall of Shop No. E62, Ground Floor

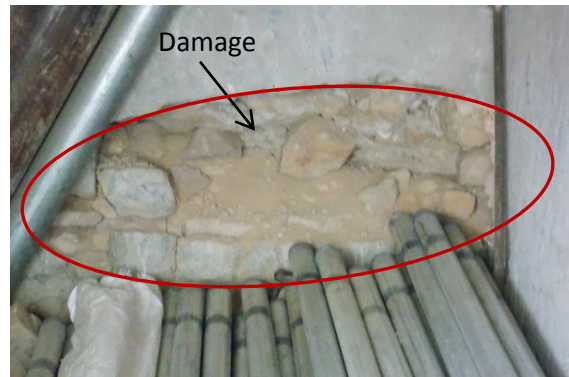
Photo 2

Damage of Wall No. 4 of Shop No. E62, Ground Floor
