Pre Building Condition Survey Report

Name and Address of Structure :	Choti Chopar to Badi Chopar (UP Line)
---------------------------------	---------------------------------------

Name of the Project	Contract JMRC-UG1B “Design and Construction of Tunnel between Chandpole and Badi Chouper and reverse line by Shield TBM, Underground Metro Stations at Choti Chouper and Badi Chouper by Cut and Cover Methods on East West Corridor of Jaipur Metro Rail Corporation Limited .”	
Owner :

Shoping Complex - Shop No. 169-188
Tripolia Bazar
Jaipur
Unique ID: CC BC UP 0001

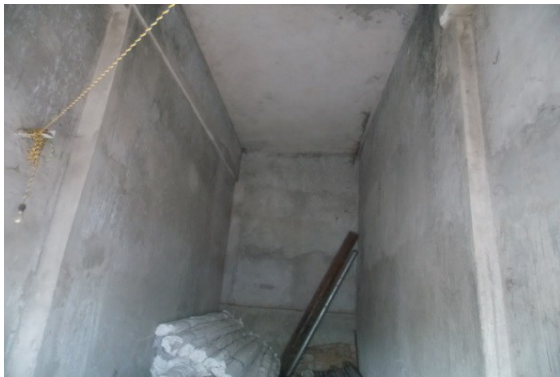
Photo 3

Repairing Work on All Walls of Shop No. E62, Ground Floor
