Pre Building Condition Survey Report

Name and Address of Structure :	Badi Chopar Station Area
---------------------------------	--------------------------

Name of the Project	Contract JMRC-UG1B “Design and Construction of Tunnel between Chandpole and Badi Chouper and reverse line by Shield TBM, Underground Metro Stations at Choti Chouper and Badi Chouper by Cut and Cover Methods on East West Corridor of Jaipur Metro Rail Corporation Limited .”	
Owner :

Pre - Condition Building Survey for Construction of Underground Stations from Chandpole to Bari Chouper and reversal line

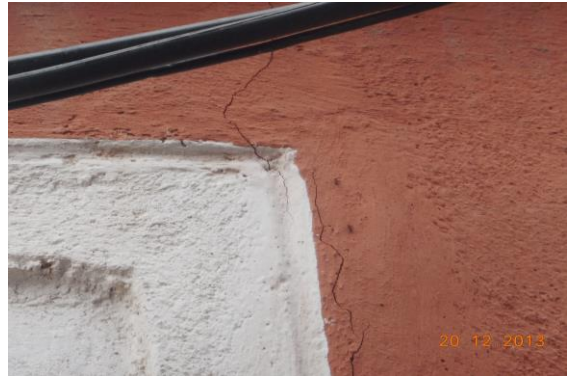
Photo 38
Inclined Crack on External Column Rightside of Varanda, Shop no.2, Ground Floor Approx. Width = 0.2mm, Approx. Length = 0.2m. Distance from External Column Left side = 2.5m, Height from Floor = 3.5m.

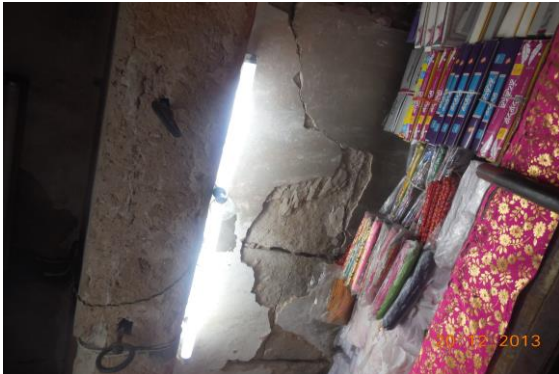
Photo 39
Inclined Crack on Roof of Shop No.2, Ground Floor
Approx. Width = 4mm, Approx. Length = 0.5m.

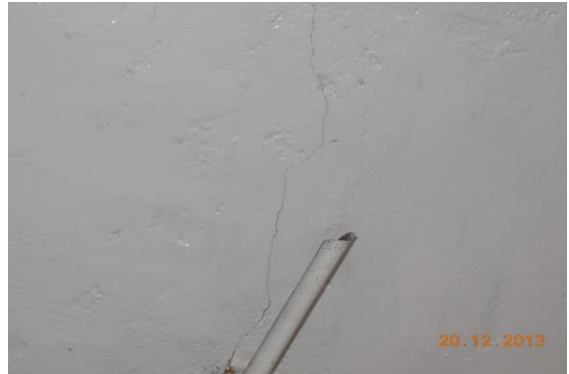
Photo 40
Horizontal Crack on Roof of Varanda, Shop no.2, Ground Floor
Approx. Width = 0.4mm, Approx. Length = 2m.
Distance External Column Left side = 1.5m, Height Floor = 3.5m.

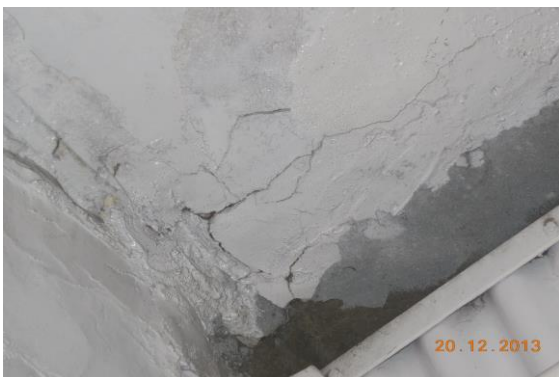
Photo 41
Inclined Crack on Roof of Varanda, Shop no.2, Ground Floor
Approx. Width = 4mm, Approx. Length = 0.5m.

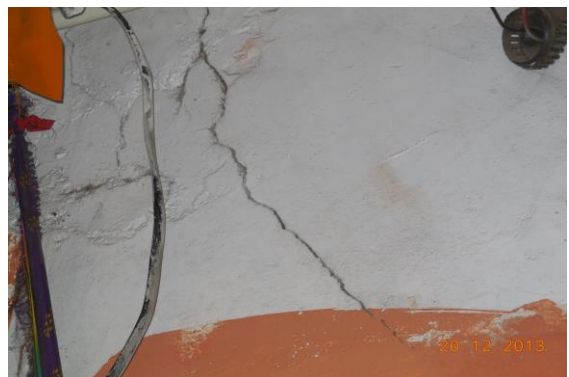
Photo 42
Horizontal Crack on Internal Column Right Side of Varanda, Shop no.2, Ground Floor Approx. Width = 2mm, Approx. Length = 0.2m. Distance Internal Column Right side = 0m, Height Floor = 3m.

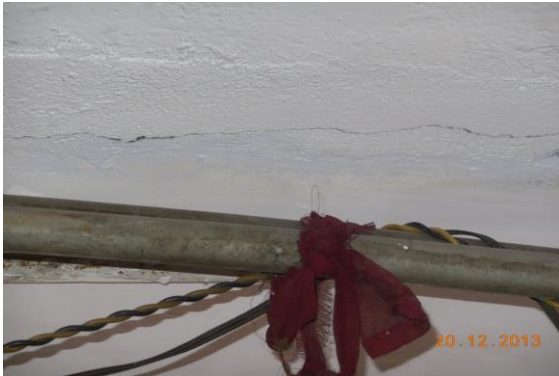
Photo 43

Horizontal Crack on Roof of Varanda, Shop no.2, Ground Floor
Approx. Width = 0.8mm, Approx. Length = 2m.
Distance Internal Column Right side = 0m, Height Floor = 3.5m.

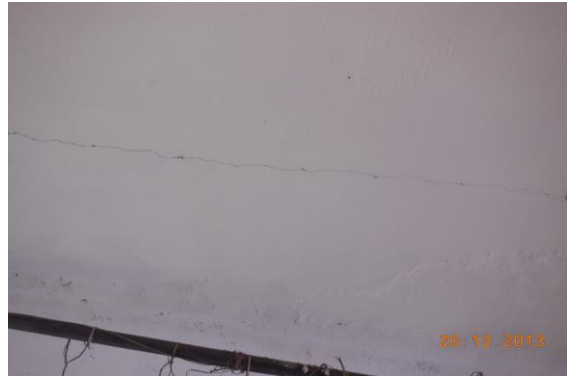
Photo 44

Horizontal Crack on Roof of Varanda, Shop no.5, Ground Floor
Approx. Width = 0.3mm, Approx. Length = 2m.
Distance External Column Left side = 0m, Height Floor = 3.5m.

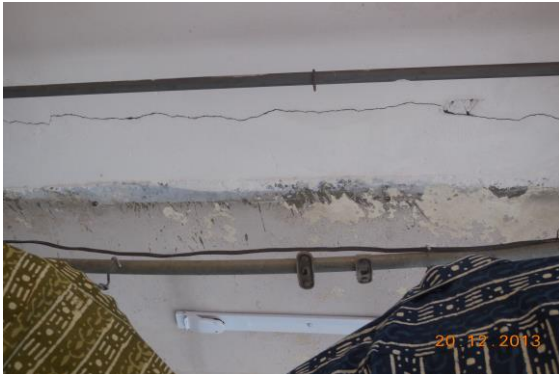
Photo 45

Horizontal Crack on Roof of Varanda, Shop no.5, Ground Floor
Approx. Width = 0.5mm, Approx. Length = 2.5m.
Distance External Column Right side = 0m, Height Floor = 3m.

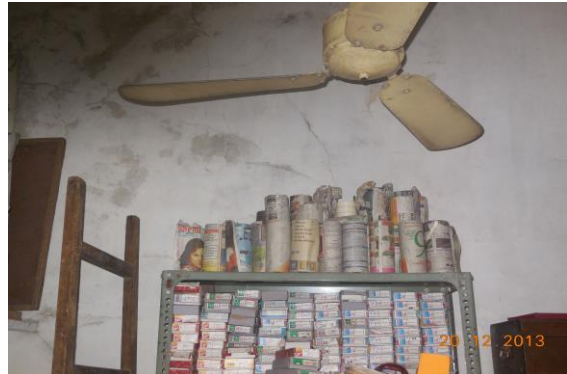
Photo 46

Inclined Crack on Wall No. 4 of Part C, Shop no.5, Ground Floor
Approx. Width = 0.5mm, Approx. Length = 1m.

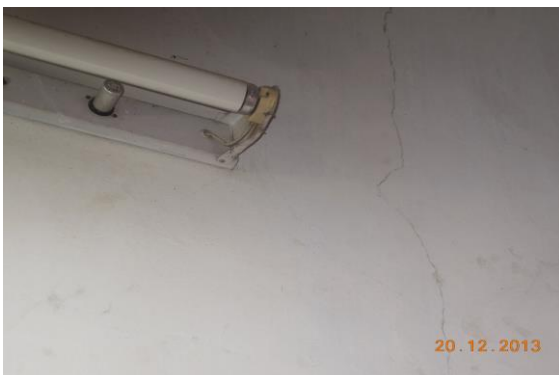
Photo 47

Inclined Crack on Wall No. 3 of Part C, Shop no.5, Ground Floor
Approx. Width = 0.5mm, Approx. Length = 1.5m.
Distance from Wall no.1 = 0.8m, Height from Floor = 1m.

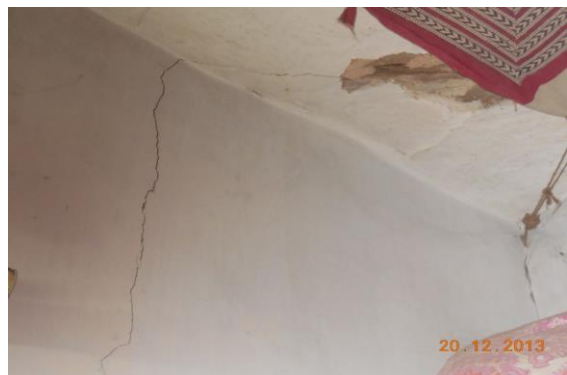
Photo 48

Inclined Crack on Roof of Part C, Shop no.5, Ground Floor
Approx. Width = 1mm, Approx. Length = 2m.

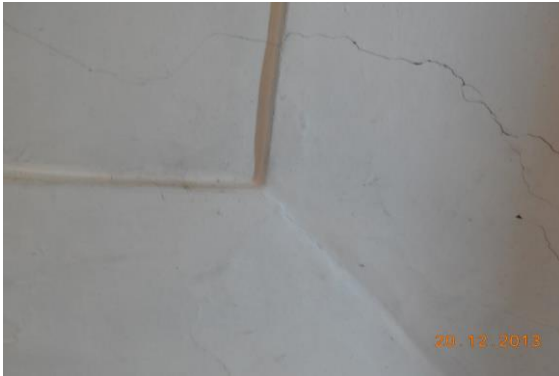
Photo 49

Inclined Crack on Wall No. 2 of Part B, Shop no.5, Ground Floor
Approx. Width = 1mm, Approx. Length = 1.5m.
Distance from Wall no.4 = 6m, Height from Floor = 2m.

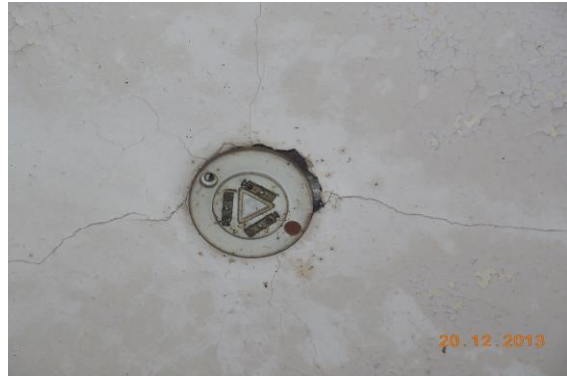
Photo 50

Inclined Crack on Roof of Varanda, Shop no.6, Ground Floor
Approx. Width = 0.5mm, Approx. Length = 2m.

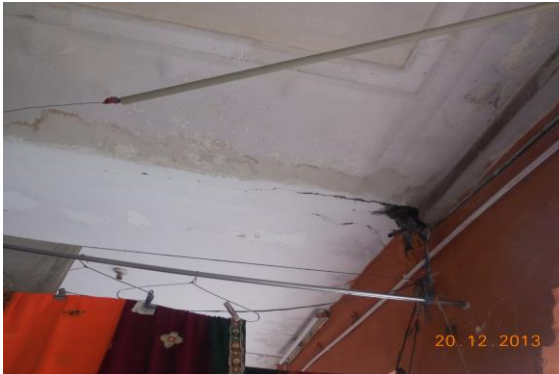
Photo 51

Inclined Crack on Roof of Varanda, Shop no.6, Ground Floor
Approx. Width = 5mm, Approx. Length = 2m.

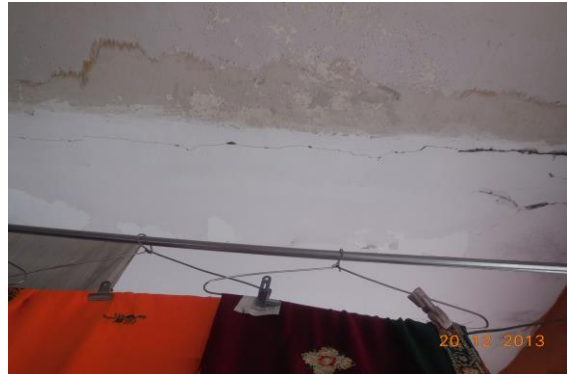
Photo 52

Horizontal Crack on Roof of Varanda, Shop no.6, Ground Floor
Approx. Width = 0.9mm, Approx. Length = 2.5m.
Distance External Column Right side = 0.6m, Height Floor = 3.5m.

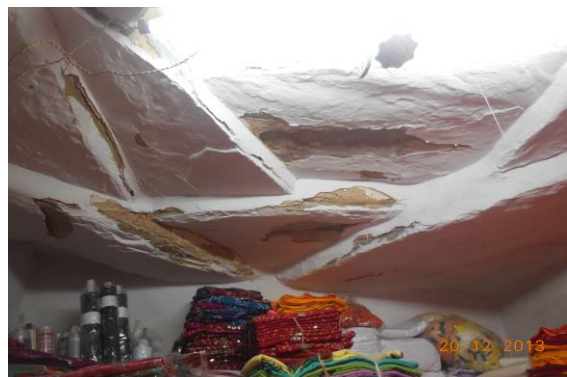
Photo 53A

Horizontal Crack on Roof of Varanda, Shop no.7, Ground Floor
Approx. Width = 0.6mm, Approx. Length = 1m.
Distance External Column Right side = 0.2m, Height Floor = 3m.

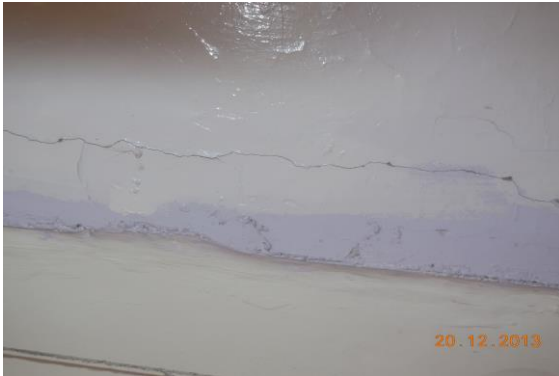
Photo 54

Horizontal Crack on Roof of Varanda, Shop no. 9, Ground Floor
Approx. Width = 0.9mm, Approx. Length = 2.5m.
Distance External Column Left side = 0m, Height Floor = 3m.

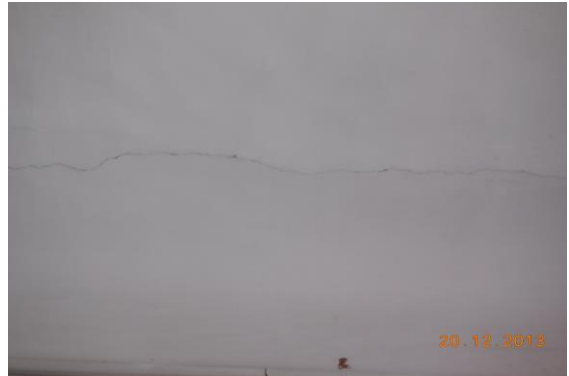
Photo 55

Horizontal Crack on Roof of Varanda, Shop no. 10, Ground Floor
Approx. Width = 2mm, Approx. Length = 2.5m.
Distance External Column Right side = 0m, Height Floor = 3m.

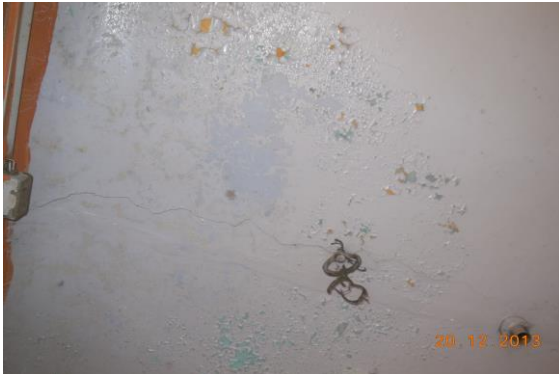
Photo 56

Inclined Crack on Roof of Varanda, Shop no. 13A, Ground Floor
Approx. Width = 0.3mm, Approx. Length = 1m.

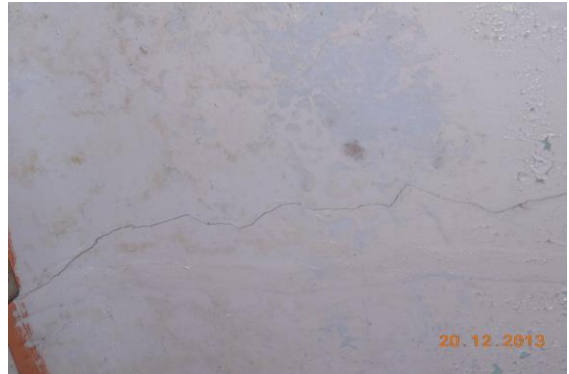
Photo 57

Horizontal Crack on Roof of Varanda, Shop no. 13A, Ground Floor
Approx. Width = 0.5mm, Approx. Length = 2.5m.
Distance External Column Right side = 0.6m, Height Floor = 3m.

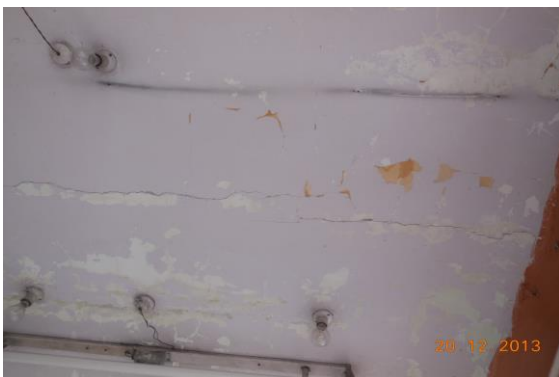
Photo 58

Horizontal Crack on Roof of Varanda, Shop no. 16, Ground Floor
Approx. Width = 1mm, Approx. Length = 2.5m.
Distance External Column Right side = 0m, Height Floor = 3m.

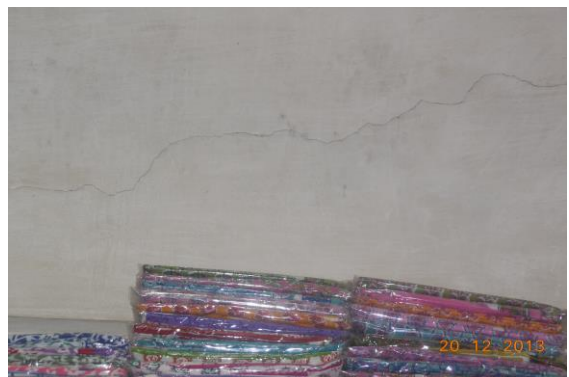
Photo 59

Inclined Crack on Roof of Part B, Shop no. 17, Ground Floor
Approx. Width = 0.3mm, Approx. Length = 2m.

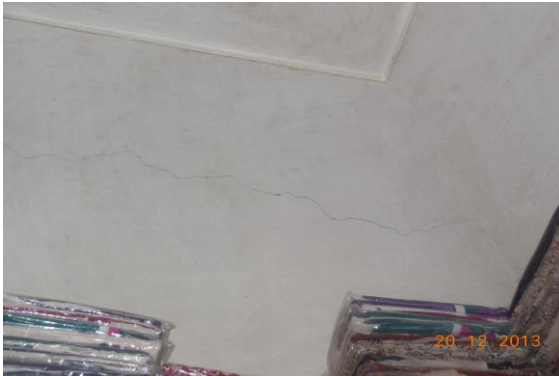
Photo 60

Inclined Crack on Roof of Part B, Shop no. 17, Ground Floor
Approx. Width = 0.5mm, Approx. Length = 1.5m.
Distance from Wall no.3 = 0.6m, Height from Floor = 3m.

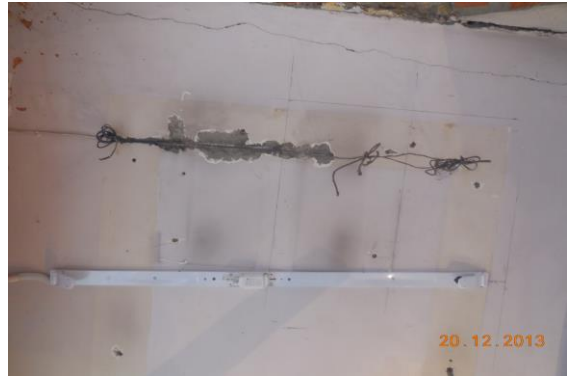
Photo 61

Inclined Crack on Roof of Shop No.18, Ground Floor
Approx. Width = 0.3mm, Approx. Length = 2m.

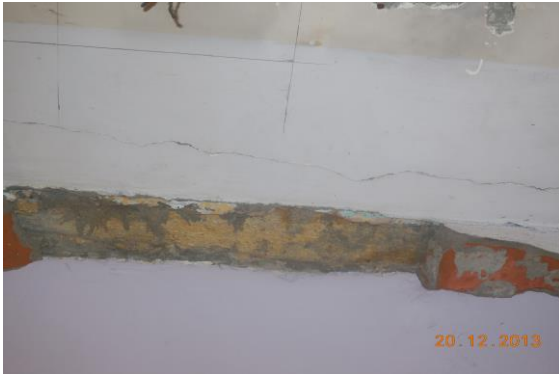
Photo 62

Horizontal Crack on Roof of Varanda, Shop no. 18, Ground Floor
Approx. Width = 2mm, Approx. Length = 2.8m.
Distance External Column Right side = 0m, Height Floor = 3m.

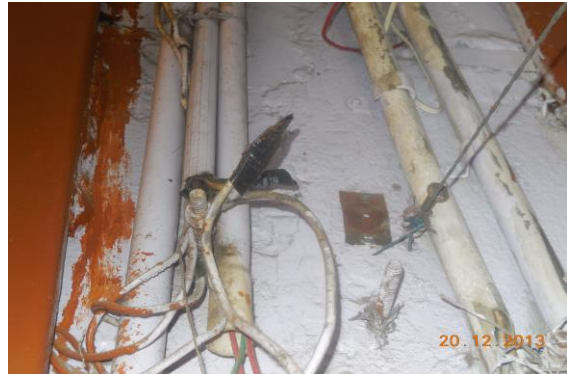
Photo 63

Inclined Crack on Outside, 3 & External Column Right side of Shop No.19, Ground Floor Approx. Width = 0.3mm, Approx. Length = 1m.
Distance External Column Left side = 7.5m, Height Floor = 1.5m.

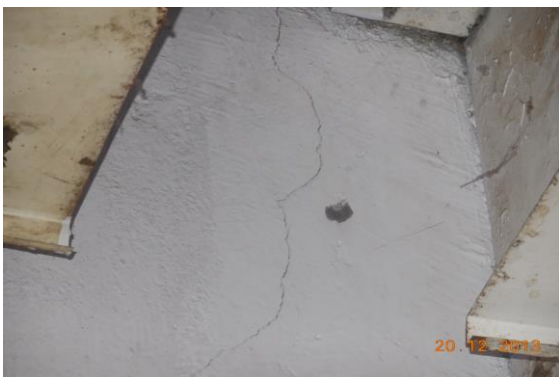
Photo 64

Inclined Crack on Outside, 3 & External Column Right side of Shop No.20, Ground floor Approx. Width = 0.4mm, Approx. Length = 1m.
Distance External Column Right side = 2m, Height Floor = 1.5m.

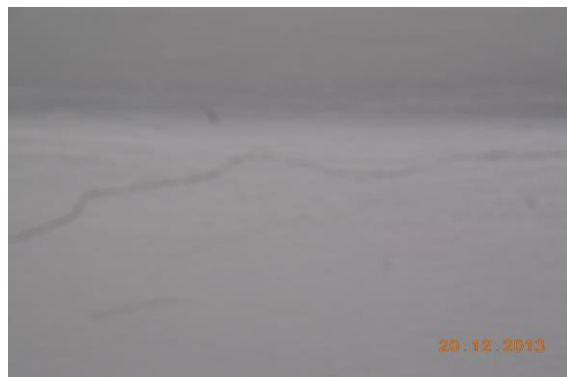
Photo 65

Inclined Crack on Roof of Shop No.2, Upper Ground Floor
Approx. Width = 0.15mm, Approx. Length = 0.6m.
Distance from Wall no.2 = 0m, Height from Floor = 3.5m.

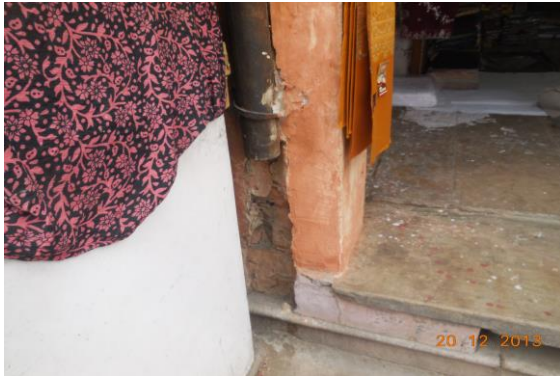
Photo 66

Damaged Portion on External Column Left side of Shop no.2 of Ground Floor

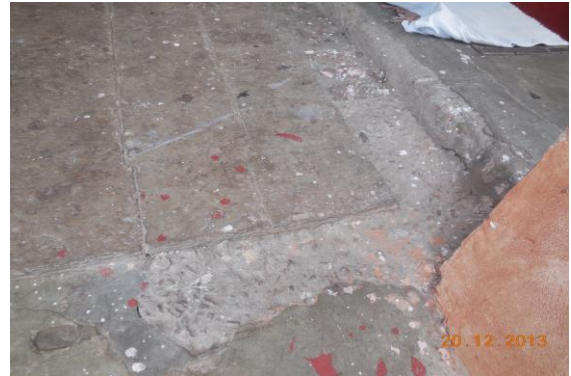
Photo 67

Damaged Portion on Floor of Varanda of Shop no.2, Ground Floor

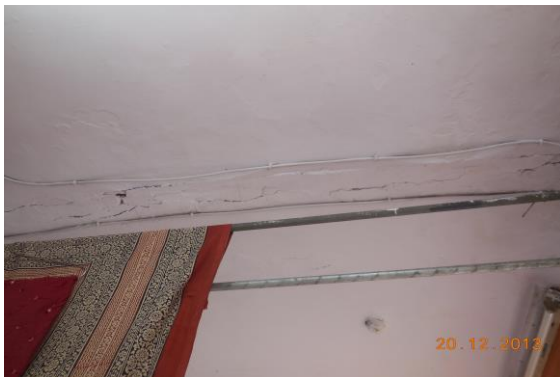
Photo 68

Peeling of Plaster on Roof of Varanda of Shop No.3 Ground Floor

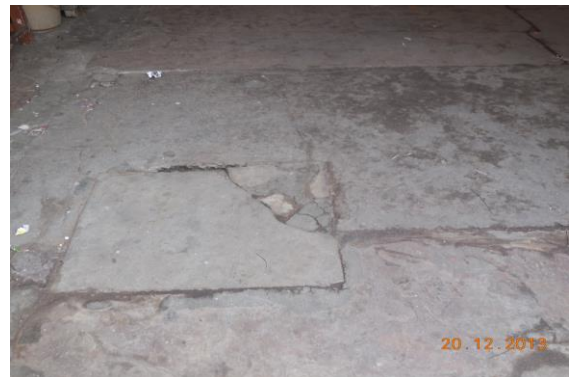
Photo 69

Damaged Portion on Floor of Varanda of Shop no.5, Ground Floor

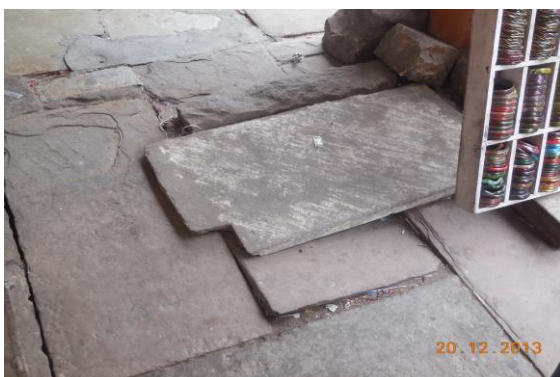
Photo 70

Damaged Portion on floor of Varanda of Shop no.5, Ground Floor

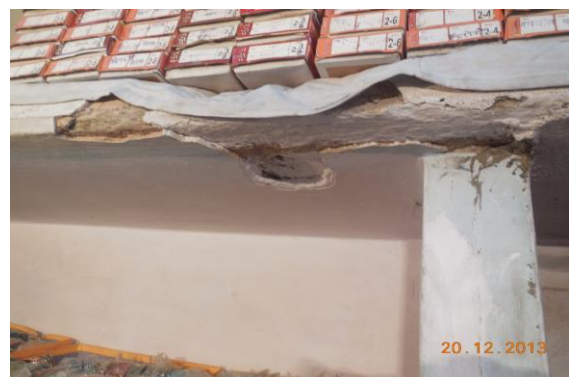
Photo 71

Damaged Portion on Wall No. 2 of Part B of Shop no.5, Ground Floor

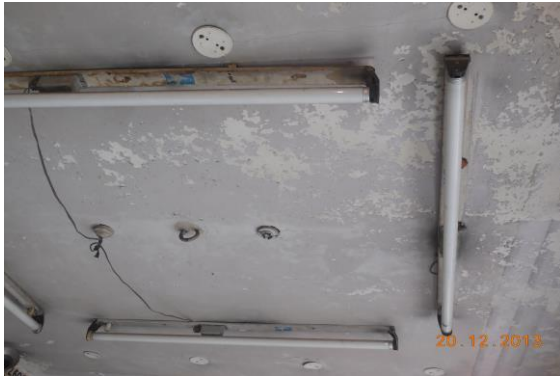
Photo 72
Dampness/Seepage on Roof of Varanda of Shop no.6, Ground Floor

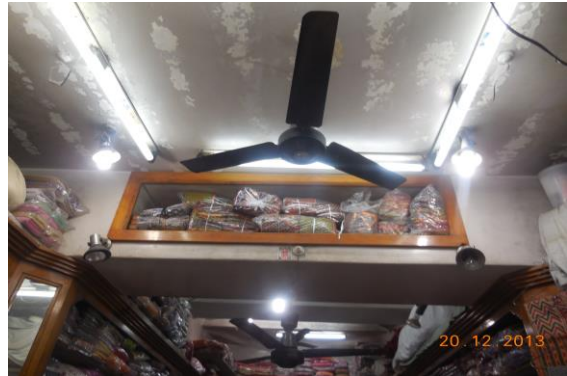
Photo 73
Peeling of Plaster on Roof of Shop No.6 of Ground Floor

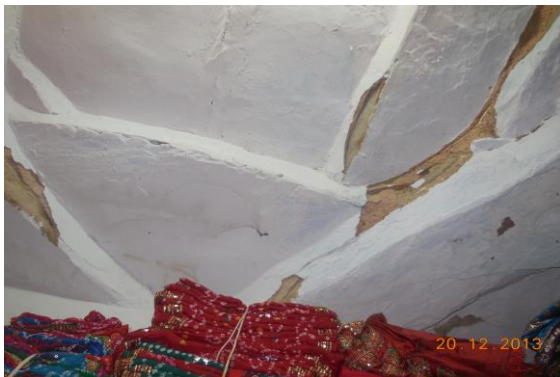
Photo 74
Damaged Portion on Roof of Shop No.7 of Ground Floor

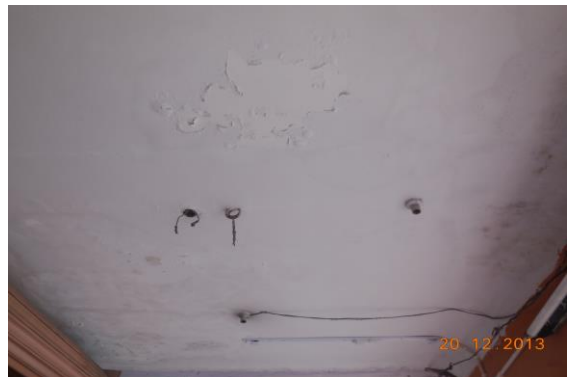
Photo 75
Dampness/Seepage on Roof of Varanda of Shop no.8, Ground Floor

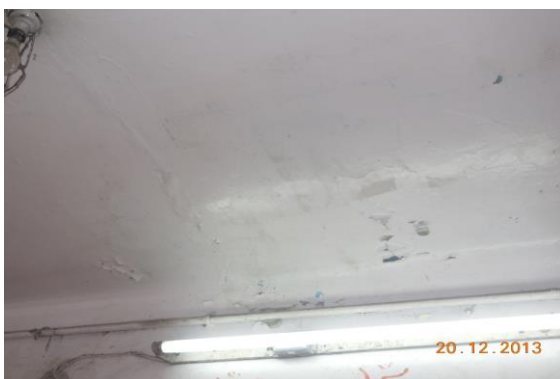
Photo 76
Peeling of Plaster on Roof of Varanda of Shop no. 9, Ground Floor

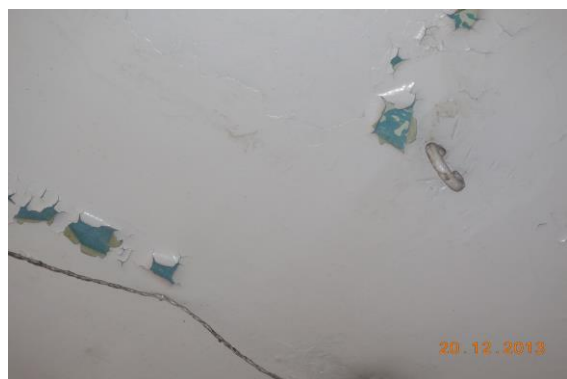
Photo 77
Peeling of Plaster on Roof of Varanda of Shop no. 9, Ground Floor

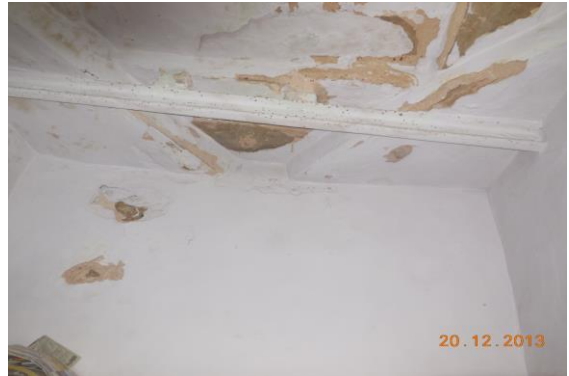
Photo 79

Damaged Portion on Wall No. 2 & Roof of Part C of Shop no. 9, Ground Floor

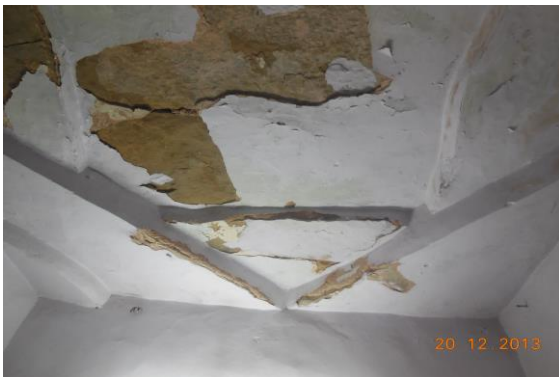
Photo 80

Peeling of Plaster on Roof of Part C of Shop no. 9, Ground Floor

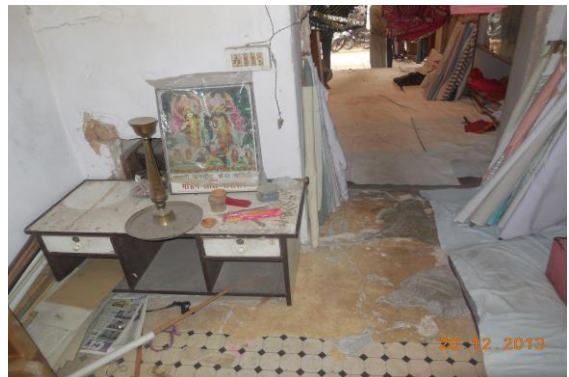
Photo 81

Peeling of Plaster on Floor & 3 of Part C of Shop no. 9, Ground Floor

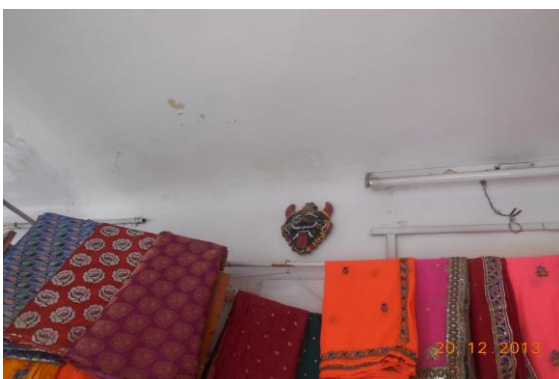
Photo 82

Peeling of Plaster on Roof of Varanda of Shop no. 10, Ground Floor

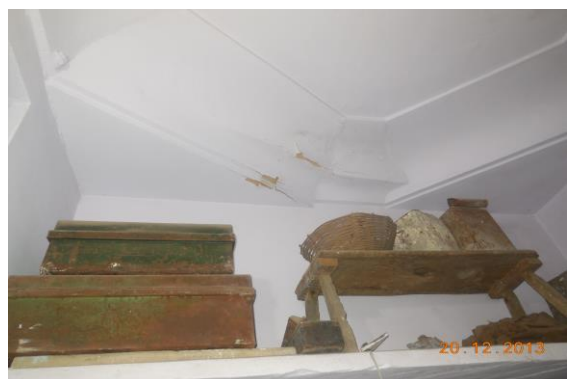
Photo 83

Peeling of Plaster on Roof of Part C of Shop no. 11, Ground Floor

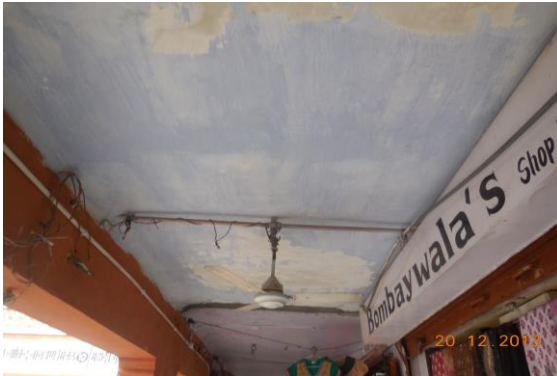
Photo 84

Dampness/Seepage on Roof of Varanda of Shop no. 14, Ground Floor

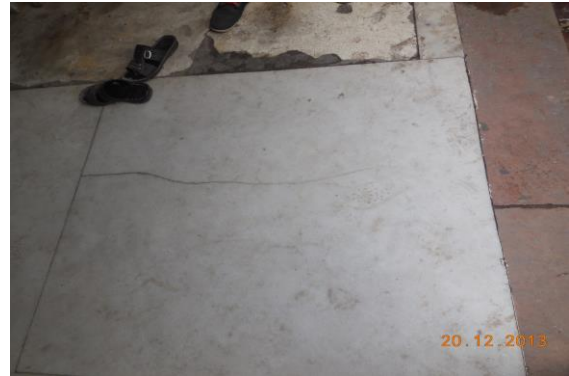
Photo 85

Damaged Portion on Floor of Varanda of Shop no. 14, Ground Floor

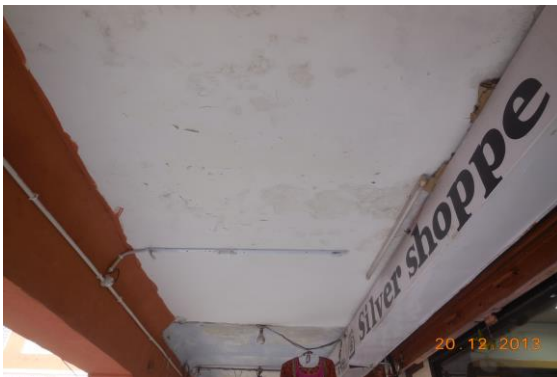
Photo 86

Dampness/Seepage on Roof of Varanda of Shop no. 15, Ground Floor

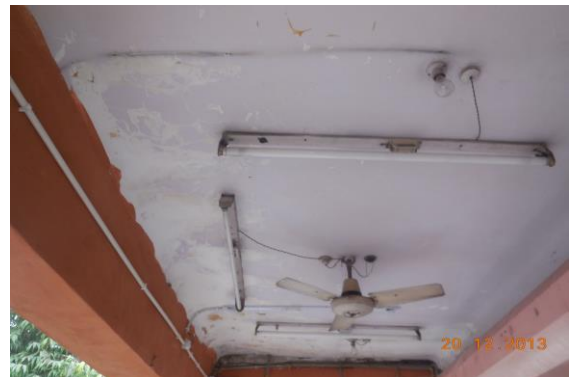
Photo 87

Dampness/Seepage on Roof of Varanda of Shop no. 16, Ground Floor

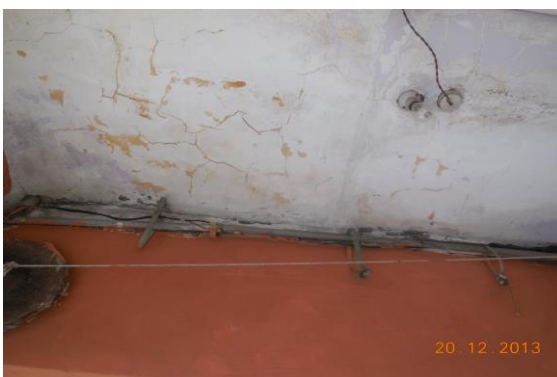
Photo 88

Dampness/Seepage on Roof of Varanda of Shop no. 16, Ground Floor

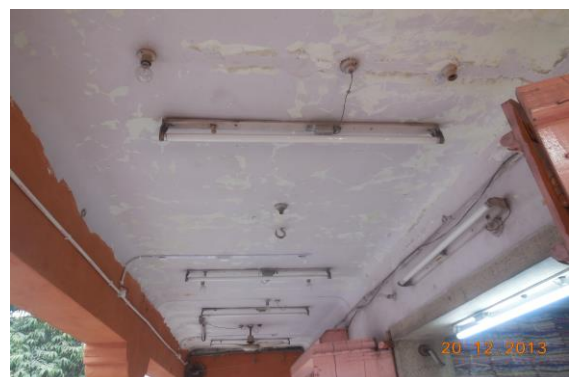
Photo 89

Peeling of Plaster on Roof of Varanda of Shop no. 17, Ground Floor

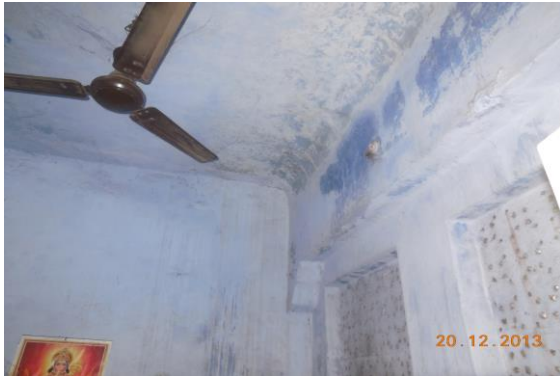
Photo 90

Dampness/Seepage on All walls & Roof of Piayu of Ground Floor

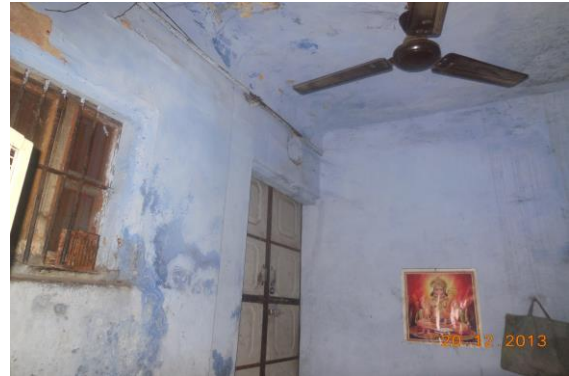
Photo 91

Dampness/Seepage on Wall No. All walls & Roof of Piayu of Ground Floor

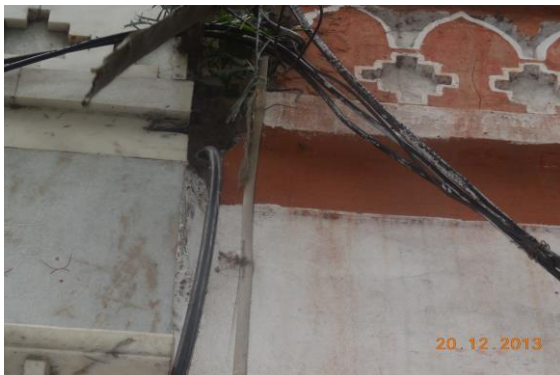
Photo 92

Damaged Portion on Out of side of Piayu of Ground Floor

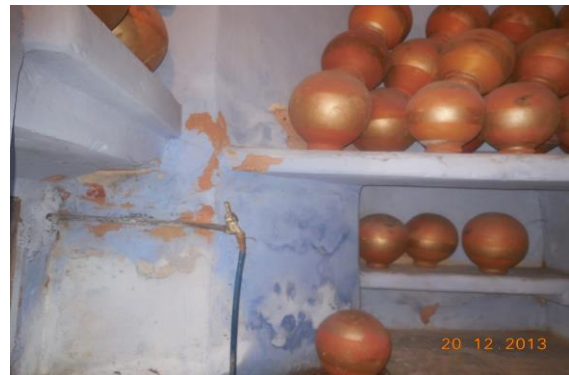
Photo 93

Peeling of Plaster on Wall No. 1 of Room No. 1 of Temple, Ground Floor

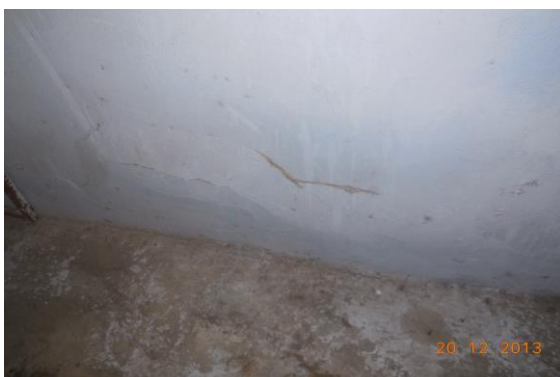
Photo 94

Peeling of Plaster on Wall No. 2 of Room No. 1 of Temple, Ground Floor

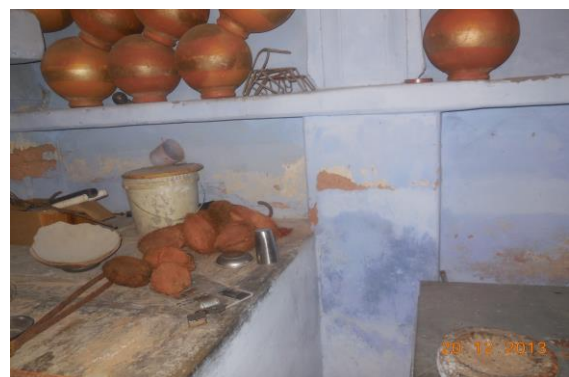
Photo 95

Peeling of Plaster on Wall No. 4 of Room No. 1 of Temple, Ground Floor

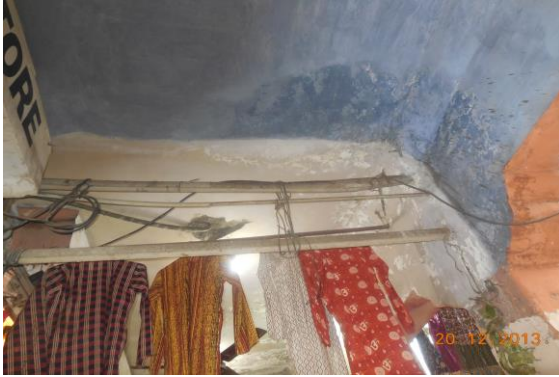
Photo 96

Dampness/Seepage on Roof of Varanda of Shop No.2, Ground Floor

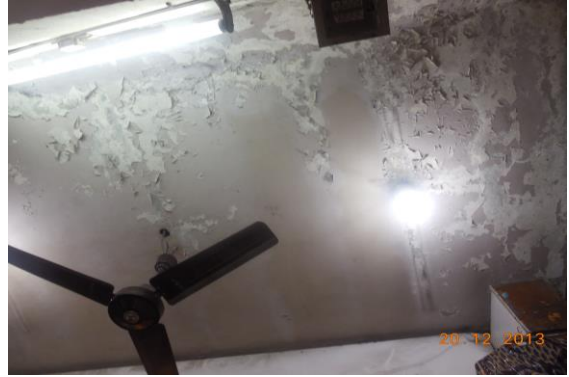
Photo 97

Peeling of Plaster on Roof of Varanda of Shop No.3, Ground Floor

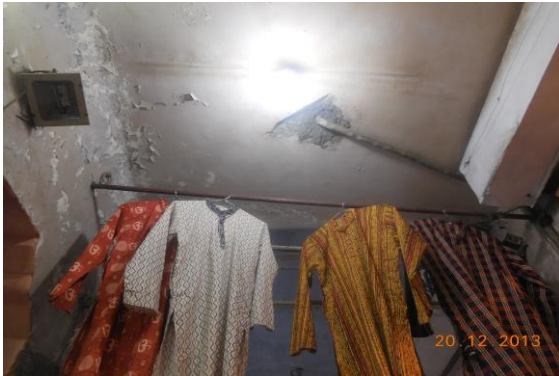
Photo 98

Peeling of Plaster on Roof of Varanda of Shop No.3, Ground Floor

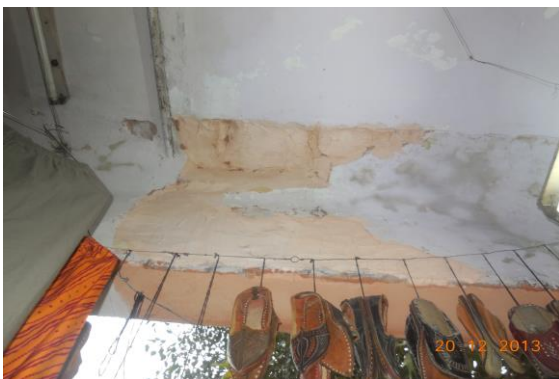
Photo 100

Damaged Portion on Roof of Varanda of Shop No.4, Ground Floor

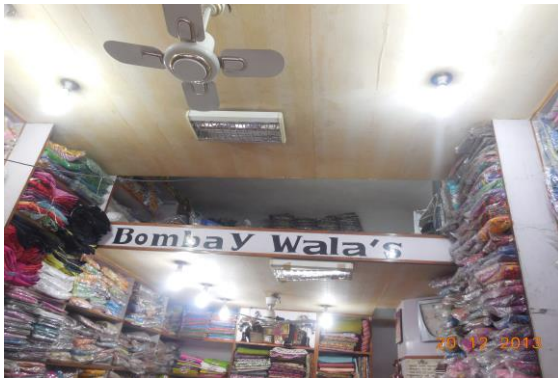
Photo 120

Roof of Shop no.14 of Ground Floor Covered with Wooden

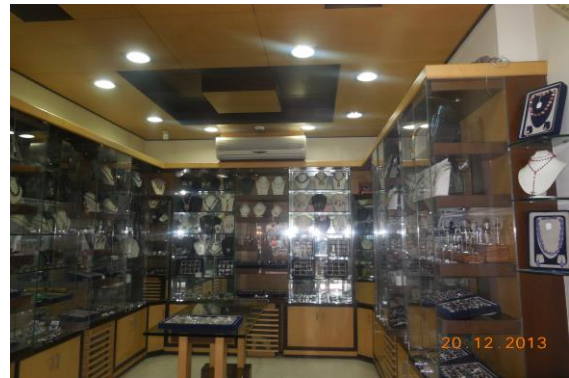
Photo 121

All Walls & Roof of Shop no.15 of Ground Floor Covered with Material & Glass work

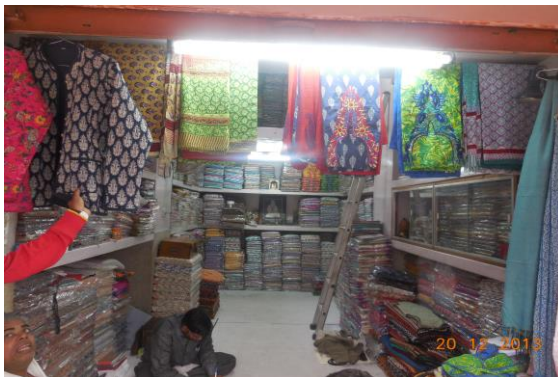
Photo 122

All Walls of Shop no.16 of Ground Floor Covered with Material

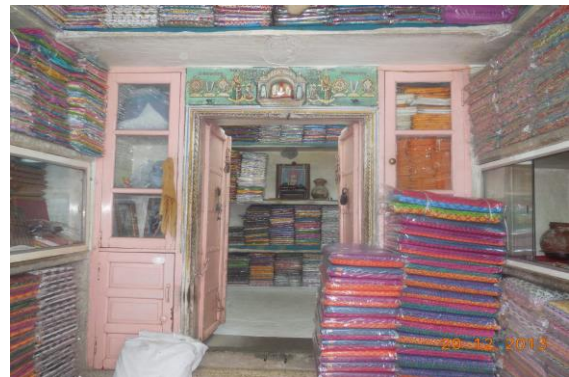
Photo 123

All Walls of Shop No.17 of Ground Floor Covered with Material

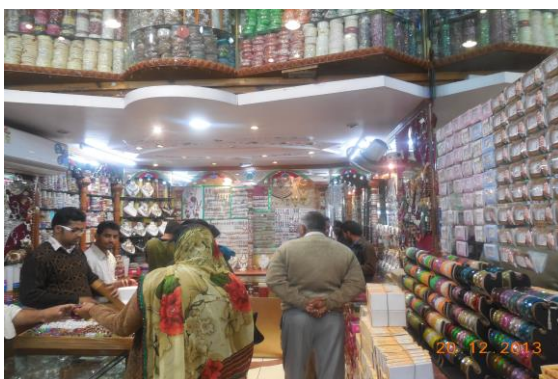
Photo 124

All Walls of Shop No.18 of Ground Floor Covered with Material

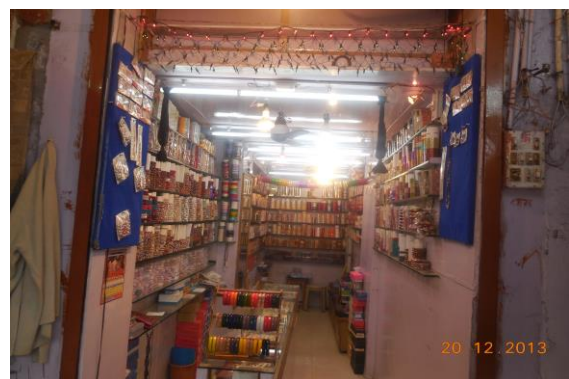
Photo 125

All Walls of Shop No.19 of Ground Floor Covered with Material

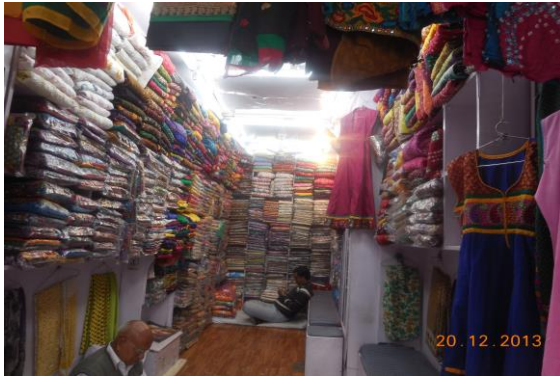
Photo 126

All Walls of Varanda of Shop no. 20, Ground Floor Covered with Material

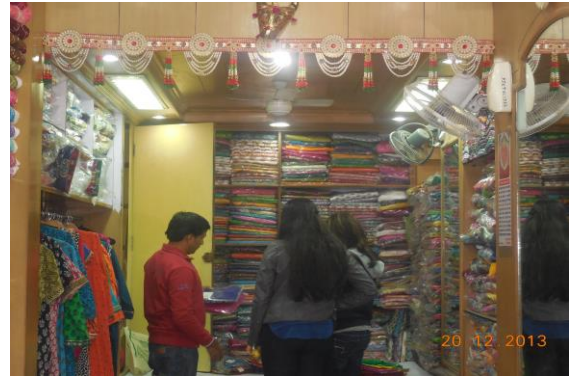
Photo 127

All Walls of Shop No.21 of Ground Floor Covered with Material & Wooden work

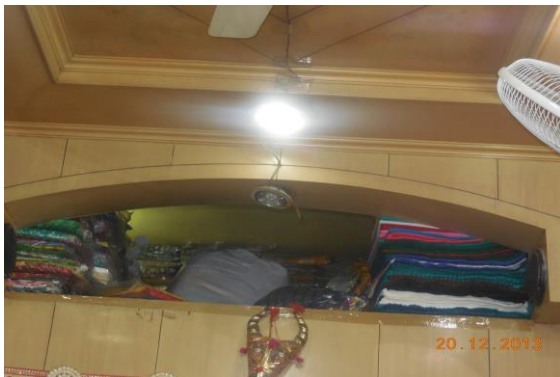
Photo 128

Roof of Shop No.21 of Ground Floor Covered with woodenwork

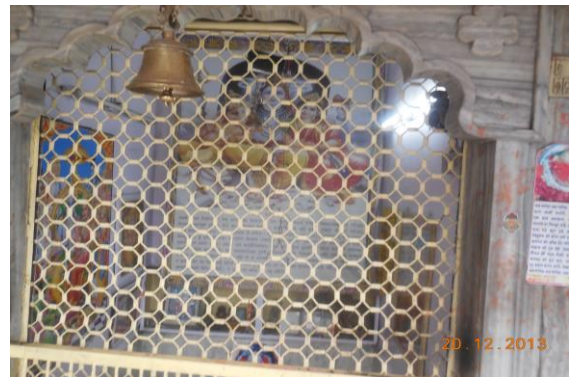
Photo 129

Temple of Ground Floor Covered With Murti

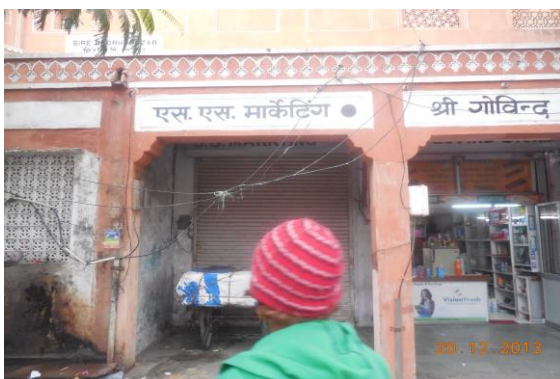
Photo 130

Shop No.1 of Ground Floor Locked

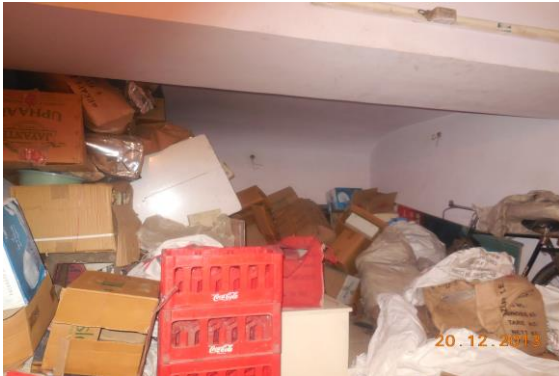
Photo 132

Floor of Shop No.2 of Upper Ground Floor Covered with Material

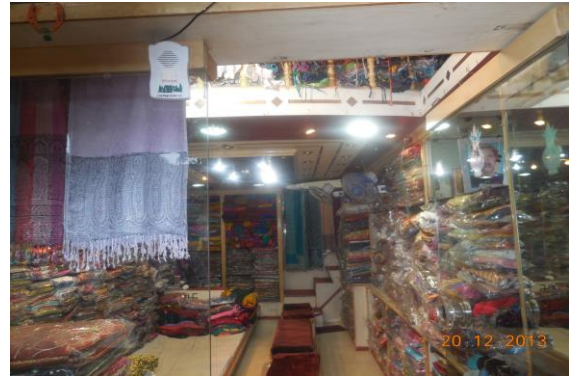
Photo 133

All walls of Shop No.3 of Ground Floor Covered with Material

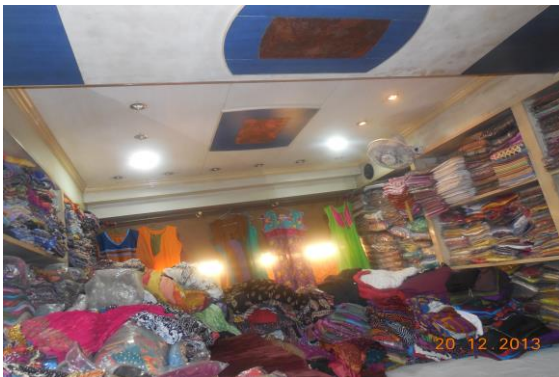
Photo 134

All walls of Shop No.3 of Upper Ground Floor Covered with Material & Wooden

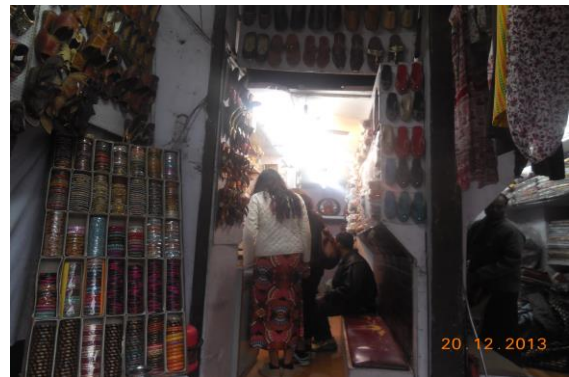
Photo 135

All walls of Shop No.4 of Ground Floor Covered with Material

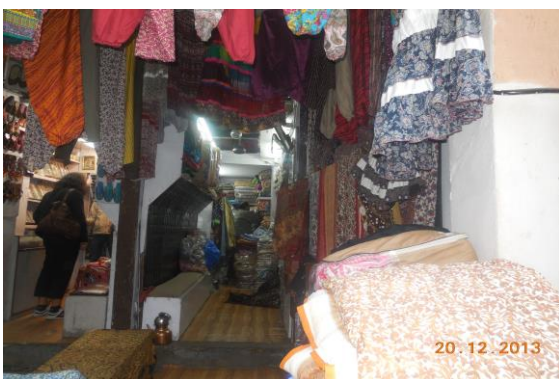
Photo 136

All walls of Shop No.5 of Ground Floor Covered with Material

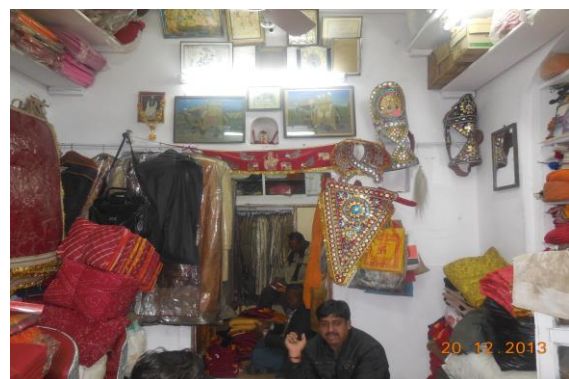
Photo 137

All walls of shop No.5 of Ground Floor Covered with Material

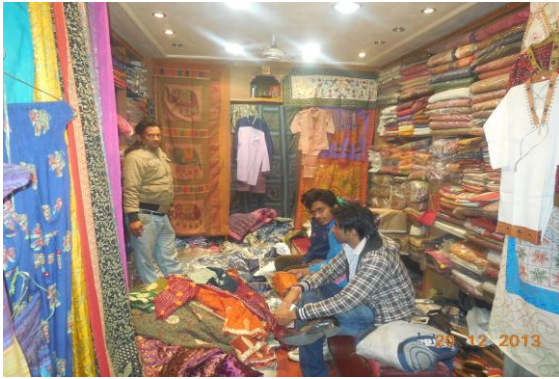
Photo 138

All walls of Shop no.6 of Ground Floor Covered with Material

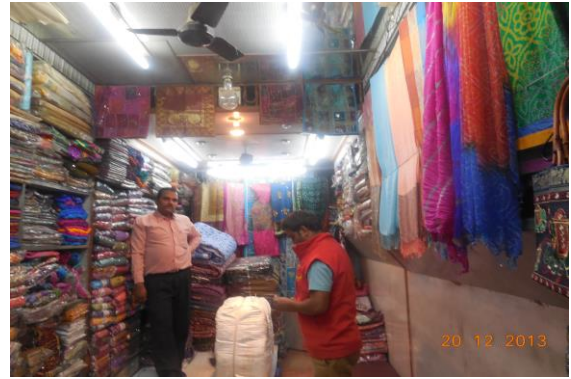
Photo 139

All walls of Shop no.7 of Ground Floor Covered with Material

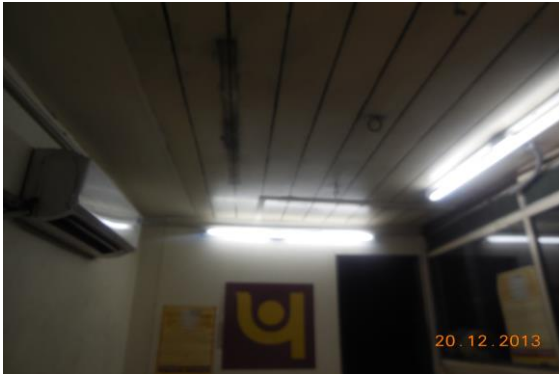
Photo 140

Roof of Shop no.8 of Ground Floor Covered with Wooden

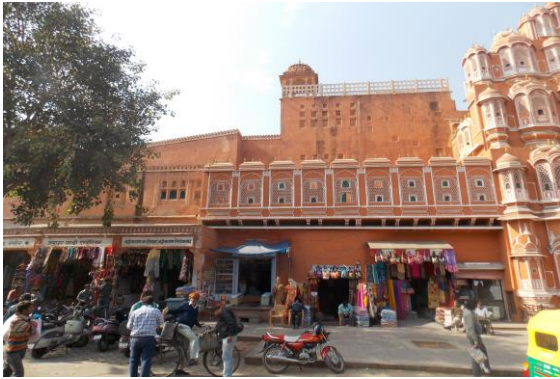
Photo 19
General View,

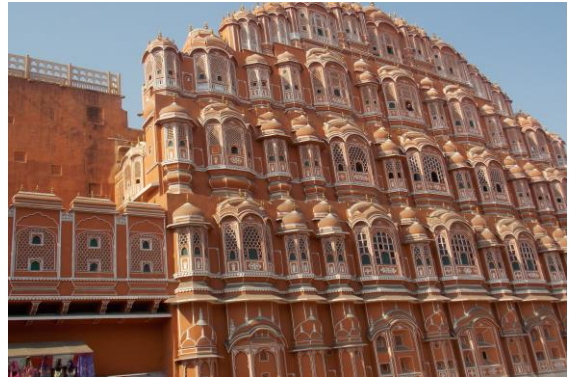
Photo 20
Back Side of Hawa Mahal,

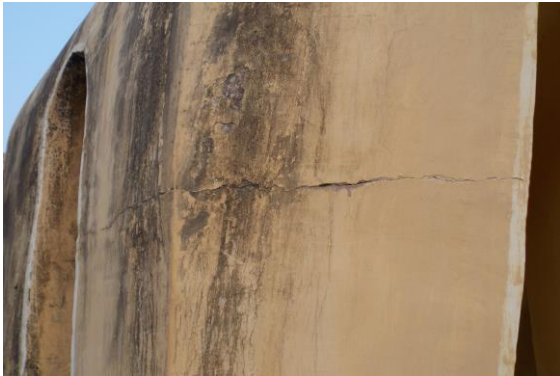
Photo 21
Horizontal Crack on of Minarate 1 L/S of Hawa Mahal , Part A1 Upper Ground Floor Approx. Width = 1mm, Approx. Length = 0.5m. Distance Wall No.1 of Gate = 0.7m, Height from Floor = 1m.

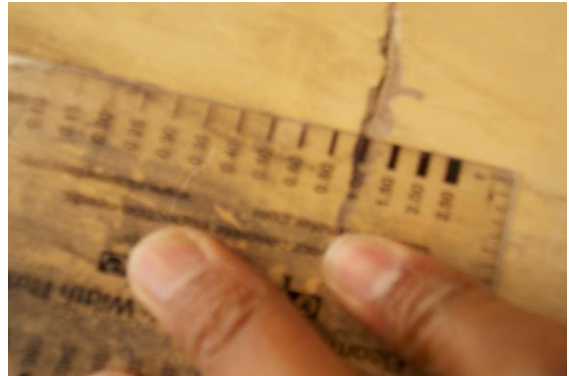
Photo 21A
Horizontal Crack on of Minarate 1 L/S of Hawa Mahal , Part A1 Upper Ground Floor Approx. Width = 1mm, Approx. Length = 0.5m Distance from Wall No.1 of Gate = 0.7m, Height from Floor = 1m.

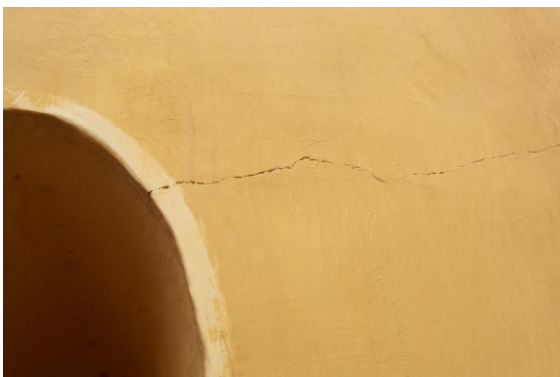
Photo 22
Horizontal Crack on of Minarate 1 L/S of Hawa Mahal , Part A1 Upper Ground Floor Approx. Width = 0.6mm, Approx. Length = 0.6m. Distance from Wall No.1 of Gate = 0m, Height Floor = 1.2m.

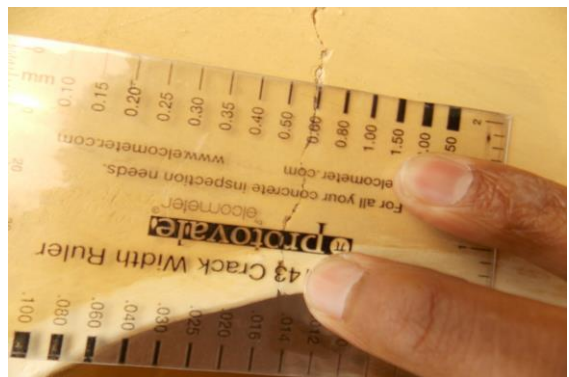
Photo 22A
Horizontal Crack on of Minarate 1 L/S of Hawa Mahal , Part A1 Upper Ground Floor Approx. Width = 0.6mm, Approx. Length = 0.6m. Distance from Wall No.1 of Gate = 0m, Height Floor = 1.2m.

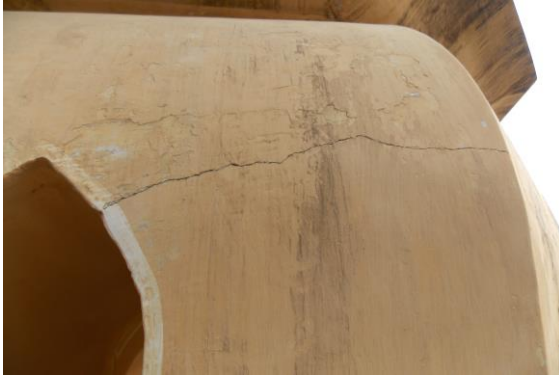
Photo 23

Horizontal Crack on of Minarate 1 R/S of Hawa Mahal , Part A1 Upper Ground Floor Approx. Width = 0.5mm, Approx. Length = 0.6m. Distance from Wall No.2 of Gate = 0.6m, Height Floor = 1.3m.

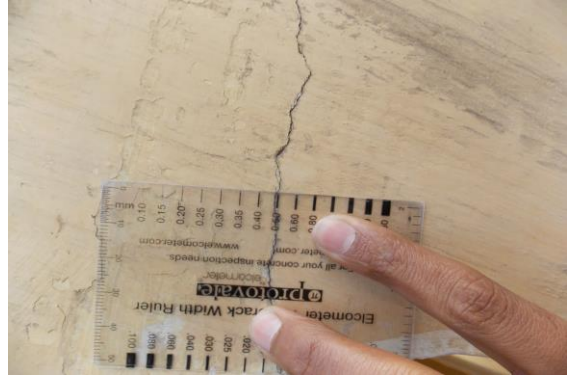
Photo 23A

Horizontal Crack on of Minarate 1 R/S of Hawa Mahal , Part A1 Upper Ground Floor Approx. Width = 0.5mm, Approx. Length = 0.6m. Distance from Wall No.2 of Gate = 0.6m, Height Floor = 1.3m.

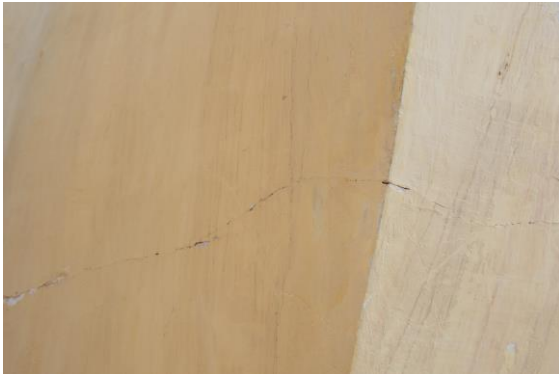
Photo 24

Horizontal Crack on of Minarate 1 R/S of Hawa Mahal , Part A1 Upper Ground Floor Approx. Width = 0.4mm, Approx. Length = 0.54m. Distance Wall No.2 of Gate = 0.44m, Height Floor = 1.12m.

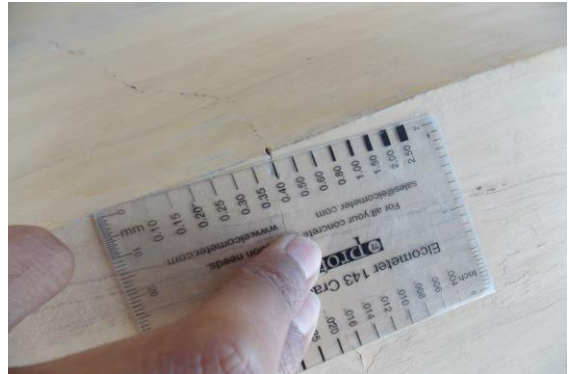
Photo 24A

Horizontal Crack on of Minarate 1 R/S of Hawa Mahal , Part A1 Upper Ground Floor Approx. Width = 0.4mm, Approx. Length = 0.54m. Distance Wall No.2 of Gate = 0.44m, Height Floor = 1.12m.

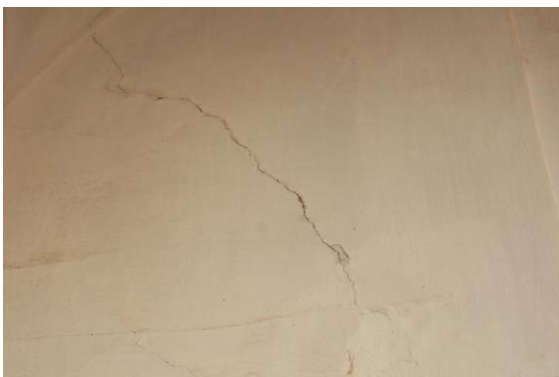
Photo 25

Inclined Crack on Wall No. 2 of Gate wall 2, Part A1 Upper Ground Floor Approx. Width = 0.25mm, Approx. Length = 1.5m. Distance from Wall No. 1 of gate = 2.5m, Height from Floor = 2.1m.

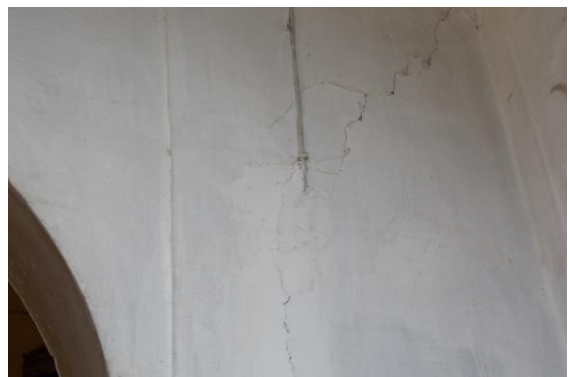
Photo 26

Horizontal Crack on Wall No. 2 of Gate wall of A2, Part A1 Upper Ground Floor Approx. Width = 0.6mm, Approx. Length = 1.2m. Distance from Wall No. 2 = 0.3m, Height from Floor = 2.2m.

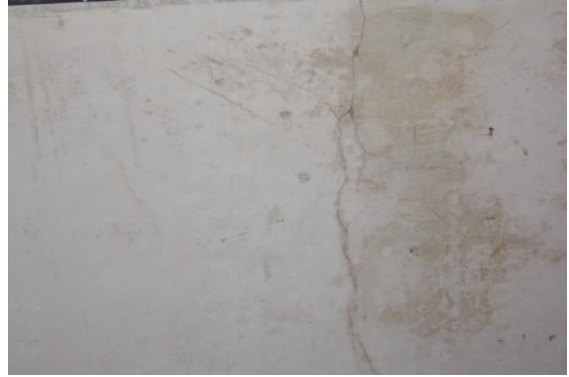
Photo 28

Inclined Crack on Wall No. 4 of Room No. 17, Part A1 Upper Ground Floor
Approx. Width = 0.4mm, Approx. Length = 2.5m. Distance from Wall No. 2 = 0.8m, Height from Floor = 0m.
