Pre Building Condition Survey Report

Name and Address of Structure :	Badi Chopar Station Area
---------------------------------	--------------------------

Name of the Project	Contract JMRC-UG1B “Design and Construction of Tunnel between Chandpole and Badi Chouper and reverse line by Shield TBM, Underground Metro Stations at Choti Chouper and Badi Chouper by Cut and Cover Methods on East West Corridor of Jaipur Metro Rail Corporation Limited .”	
Owner :

Pre - Condition Building Survey for Construction of Underground Stations from Chandpole to Bari Chouper and reversal line

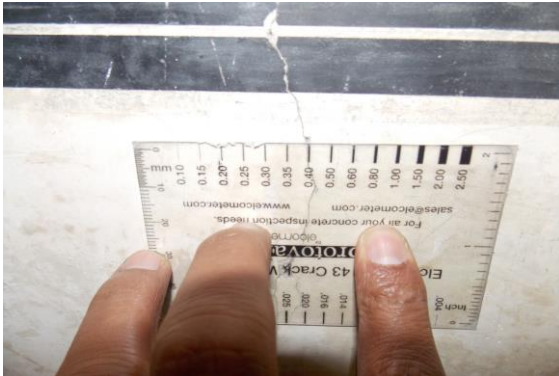
Photo 28A

Inclined Crack on Wall No. 4 of Room No. 17, Part A1 Upper Ground Floor
Approx. Width = 0.4mm, Approx. Length = 2.5m. Distance from Wall No. 2 = 0.8m, Height from Floor = 0m.

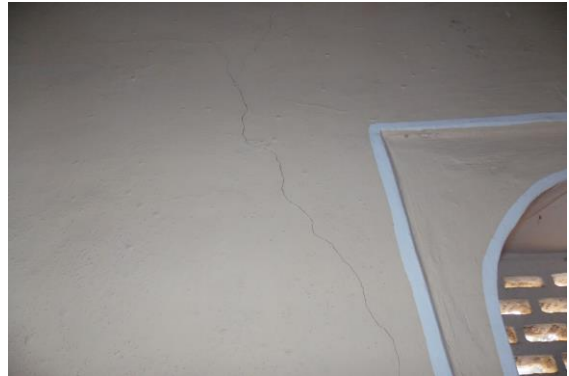
Photo 29

Inclined Crack on Wall No. 4 of Passage 1, Part A1 Upper Ground Floor
Approx. Width = 0.4mm, Approx. Length = 1m. Distance from Wall No. 2 = 2m, Height from Floor = 1.7m.

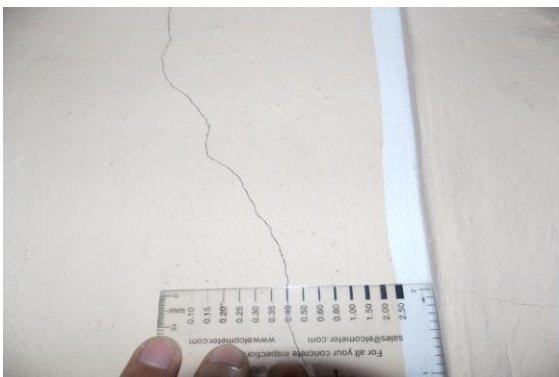
Photo 29A

Inclined Crack on Wall No. 4 of Passage 1, Part A1 Upper Ground Floor
Approx. Width = 0.4mm, Approx. Length = 1m. Distance from Wall No. 2 = 2m, Height from Floor = 1.7m.

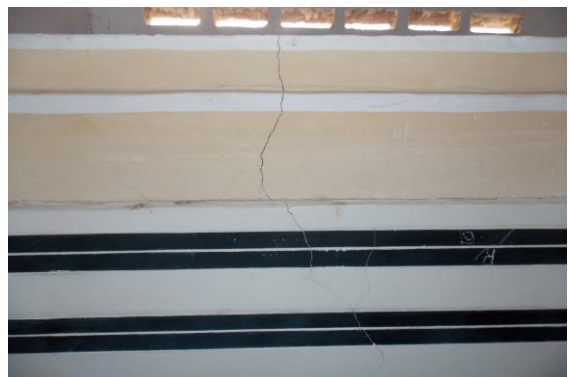
Photo 30

Inclined Crack on Wall No. 4 of Passage 1, Part A1 Upper Ground Floor
Approx. Width = 0.6mm, Approx. Length = 2m. Distance from Wall No. 2 = 1.5m, Height from Floor = 0m.

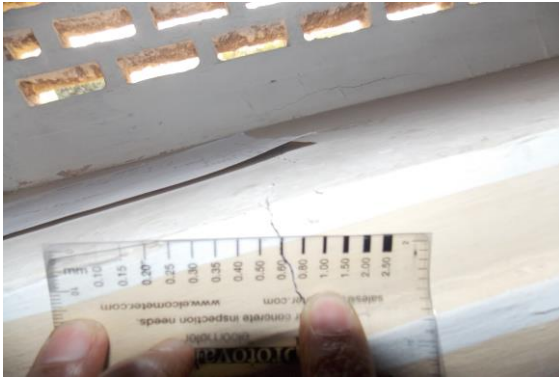
Photo 30A

Inclined Crack on Wall No. 4 of Passage 1, Part A1 Upper Ground Floor
Approx. Width = 0.6mm, Approx. Length = 2m. Distance from Wall No. 2 = 1.5m, Height from Floor = 0m.

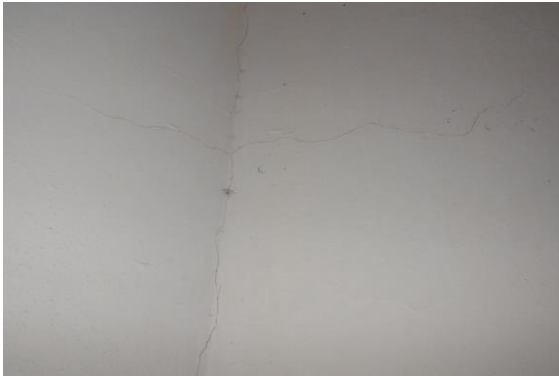
Photo 31A

Inclined Crack on Wall No. 2 of Minaret 3, Part A1 Upper Ground Floor
Approx. Width = 0.5mm, Approx. Length = 4.8m. Distance from = m, Height from Floor = 0m.

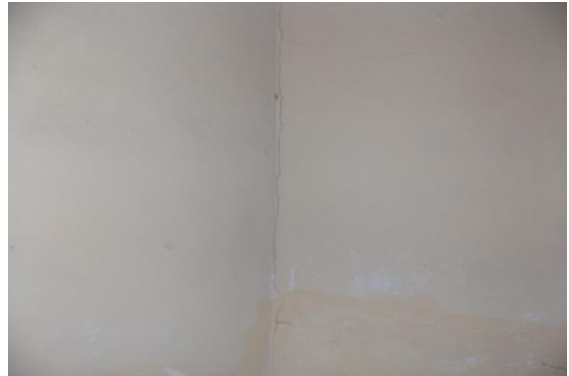
Photo 32

Inclined Crack on Wall No. 2 of Minaret 3, Part A1 Upper Ground Floor
Approx. Width = 0.5mm, Approx. Length = 4.8m. Distance from = m, Height from Floor = 0m.

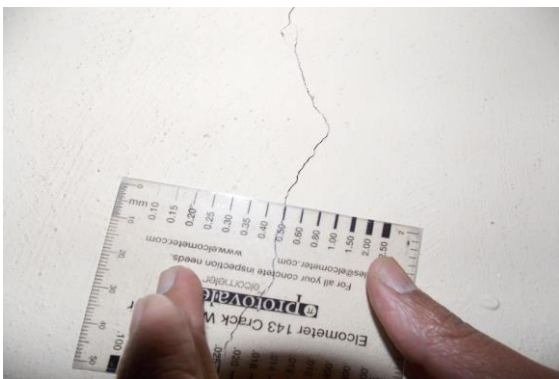
Photo 33

Inclined Crack on Wall No. 2 of Minaret 3, Part A1 Upper Ground Floor
Approx. Width = 0.5mm, Approx. Length = 4.8m. Distance from = m, Height from Floor = 0m.

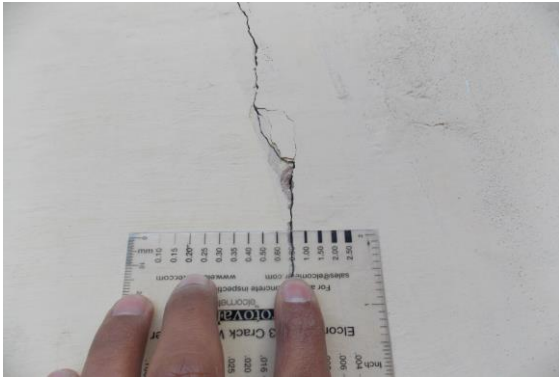
Photo 34A

Inclined Crack on Wall No. 4 of Open Area Part A 1, Part A1 Upper Ground Floor Approx. Width = 0.8mm, Approx. Length = 1.3m. Distance from Wall No. 1 = 6.5m, Height from Floor = 1.1m.

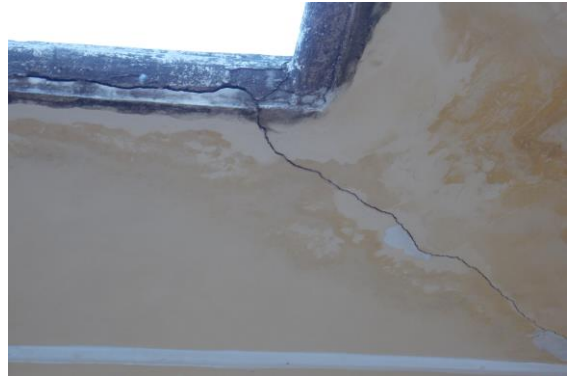
Photo 36

Inclined Crack on Wall No. 3 & 2 of Corner Sky open Part A1, Part A1 Upper Ground Floor Approx. Width = 5mm, Approx. Length = 2.5m. Distance from Wall No. 2 & 3 = 0m, Height from Floor = 3.5m.

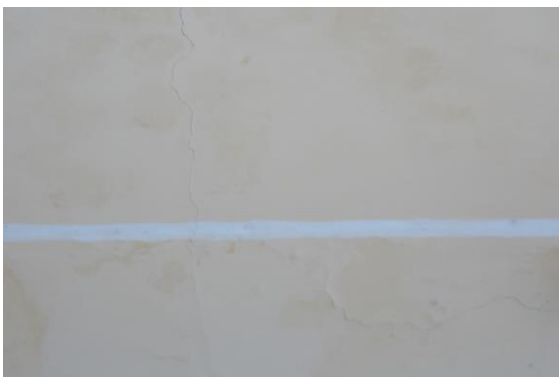
Photo 37

Inclined Crack on Wall No. 1 & Sunshade of Open Area Part A 1, Part A1 Upper Ground Floor Approx. Width = 0.25mm, Approx. Length = 2m. Distance from Wall No. 3 = 6m, Height Floor = 3.5m.

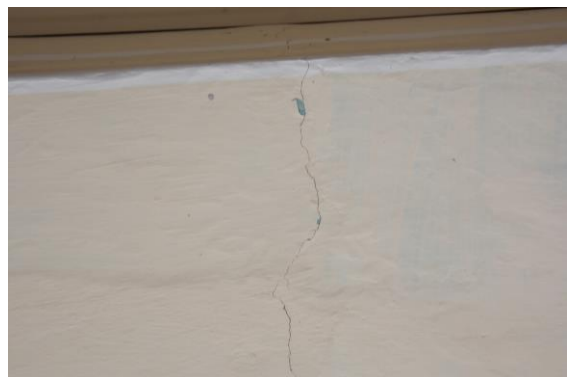
Photo 38

Inclined Crack on Wall No. 3 & Roof of Vrandha 3, Part A2 Upper Ground Floor Approx. Width = 0.25mm, Approx. Length = 1.5m. Distance from Wall No. 1 = 3.4m, Height from Floor = 2.7m.

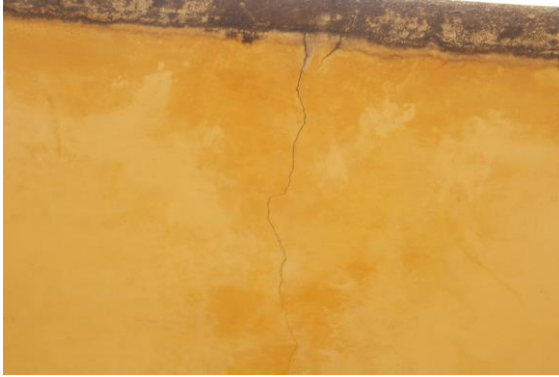
Photo 39

Horizontal Crack on Wall No. 3 of Sunshade, Part A2 Upper Ground Floor Approx. Width = 0.5mm, Approx. Length = 0.8m. Distance from Wall No. 1 = 2.15m, Height from Floor = 3.5m.

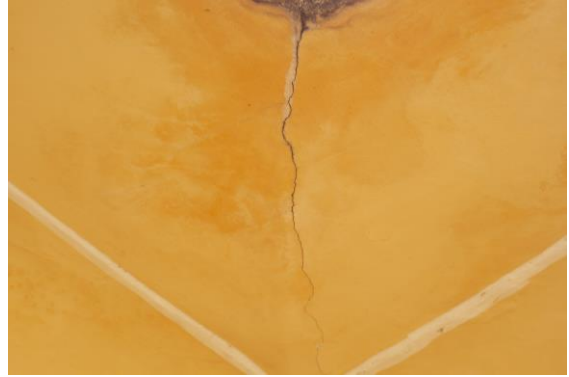
Photo 40

Inclined Crack on Wall No. 1 & 3 of Corner of sunshade, Part A2 Upper Ground Floor Approx. Width = 0.8mm, Approx. Length = 2m. Distance from Wall No 1 & 3 Corner = 0m, Height Floor = 3.5m.

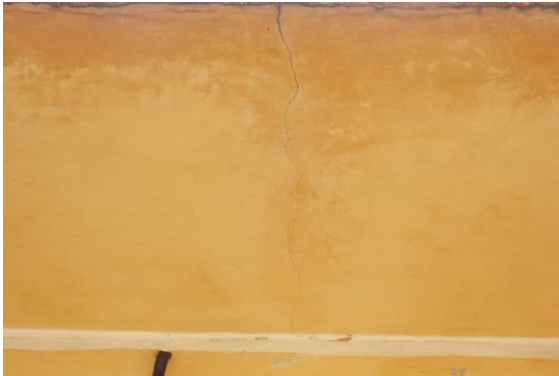
Photo 41

Inclined Crack on Wall No. 2 of Open Area, Part A2 Upper Ground Floor Approx. Width = 0.4mm, Approx. Length = 0.6m. Distance from Wall No. 3 = 3.5m, Height from Floor = 3.5m.

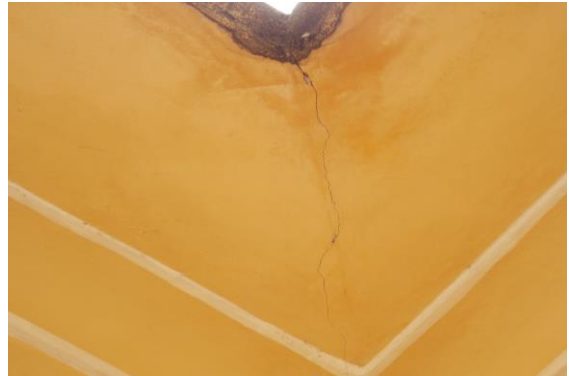
Photo 42

Inclined Crack on Wall No. 1 & 2 of Open Area, Part A2 Upper Ground Floor Approx. Width = 0.8mm, Approx. Length = 2m. Distance from Wall No. 1 & 2 Corner = 0m, Height from Floor = m.

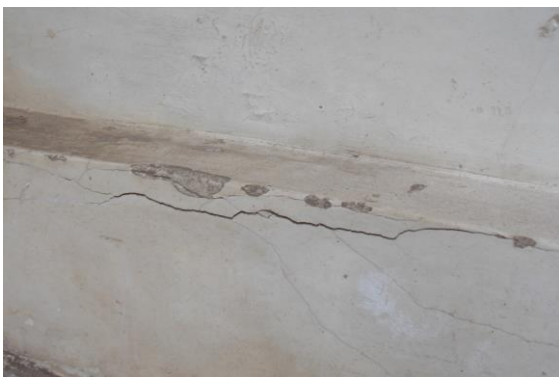
Photo 43

Horizontal Crack on Wall No. 2 of Open Area, Part A2 Upper Ground Floor Approx. Width = 1mm, Approx. Length = 0.3m. Distance from Wall No. 4 = 0.25m, Height from Floor = 0.2m.

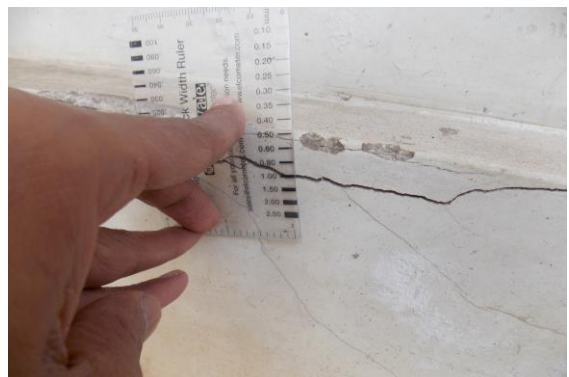
Photo 43A

Horizontal Crack on Wall No. 2 of Open Area, Part A2 Upper Ground Floor Approx. Width = 1mm, Approx. Length = 0.3m. Distance from Wall No. 4 = 0.25m, Height from Floor = 0.2m.

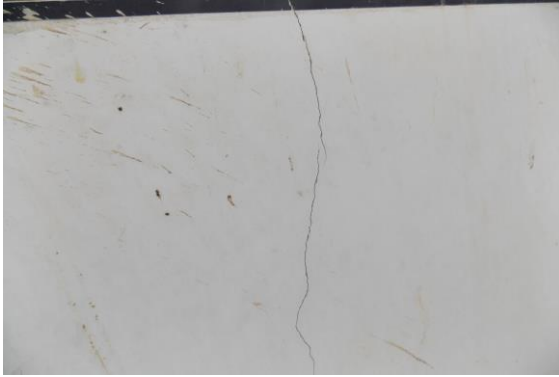
Photo 44

Inclined Crack on Wall No. 4 of Open Area , Part A2 Upper Ground Floor Approx. Width = 0.8mm, Approx. Length = 1.35m. Distance from Wall No. 1 = 6.7m, Height from Floor = 0.6m.

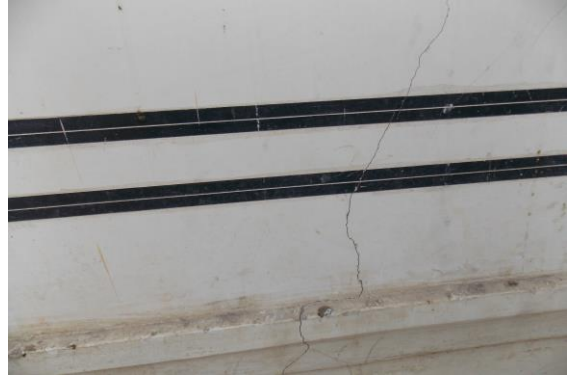
Photo 44A

Inclined Crack on Wall No. 4 of Open Area , Part A2 Upper Ground Floor Approx. Width = 0.8mm, Approx. Length = 1.35m. Distance from Wall No. 1 = 6.7m, Height from Floor = 0.6m.

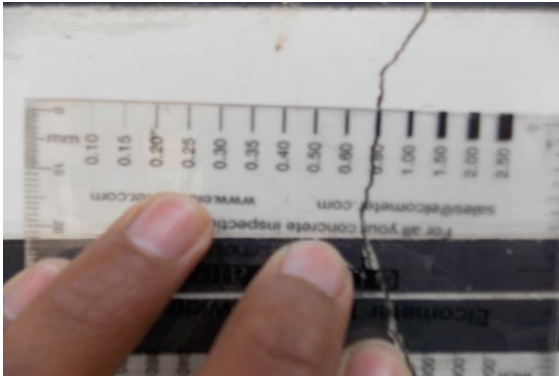
Photo 45

Inclined Crack on Wall No. 4 of Open Area , Part A2 Upper Ground Floor Approx. Width = 0.5mm, Approx. Length = 1.3m. Distance from Wall No. 1 = 6.3m, Height from Floor = 0m.

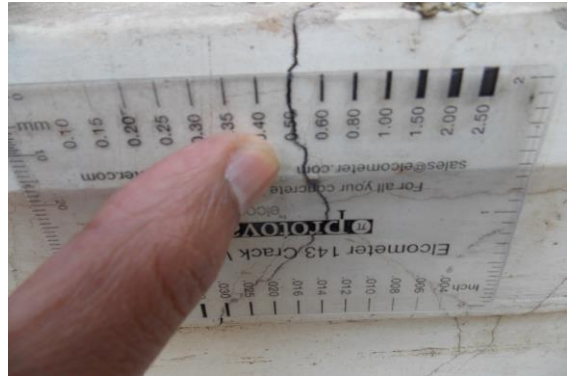
Photo 45A

Inclined Crack on Wall No. 4 of Open Area , Part A2 Upper Ground Floor Approx. Width = 0.5mm, Approx. Length = 1.3m. Distance from Wall No. 1 = 6.3m, Height from Floor = 0m.

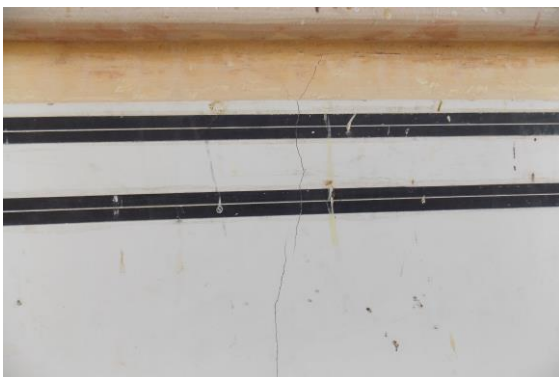
Photo 46

Inclined Crack on Wall No. 4 of Open Area , Part A2 Upper Ground Floor Approx. Width = 0.5mm, Approx. Length = 1.25m. Distance from Wall No. 1 = 2.7m, Height from Floor = 0.5m.

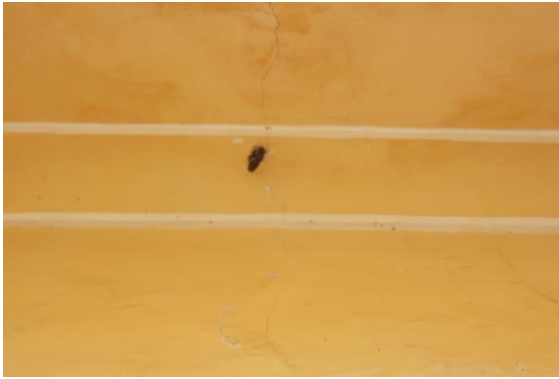
Photo 47

Inclined Crack on Wall No. 4 & Sunshade of Open Area, Part A2 Upper Ground Floor Approx. Width = 1mm, Approx. Length = 2.5m. Distance from Wall No. 1 = 2.3m, Height from Floor = 2m.

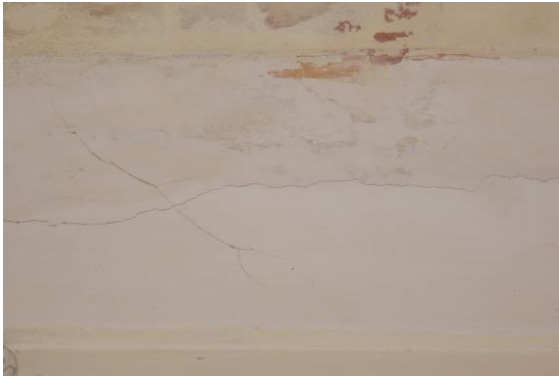
Photo 49

Horizontal Crack on Wall No. 3 of Gallery 1 W 3 to Roof, Part A2 Upper Ground Floor Approx. Width = 0.6mm, Approx. Length = 3.5m. Distance from Wall No. 3 = 0m, Height from Floor = 3.3m.

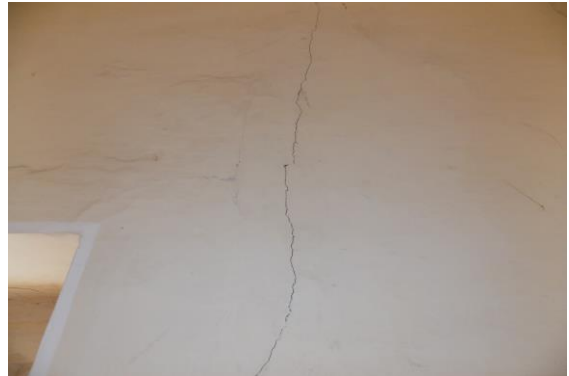
Photo 50

Inclined Crack on Wall No. 3 of Gallery 2, Part A2 Upper Ground Floor Approx. Width = 0.4mm, Approx. Length = 1.35m. Distance from Wall No. 1 = 10.4m, Height from Floor = 1.67m.

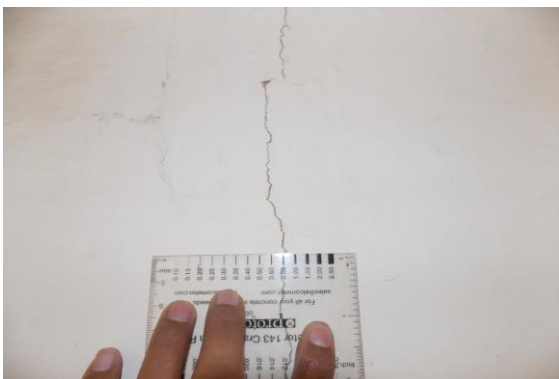
Photo 50A

Inclined Crack on Wall No. 3 of Gallery 2, Part A2 Upper Ground Floor Approx. Width = 0.4mm, Approx. Length = 1.35m. Distance from Wall No. 1 = 10.4m, Height from Floor = 1.67m.

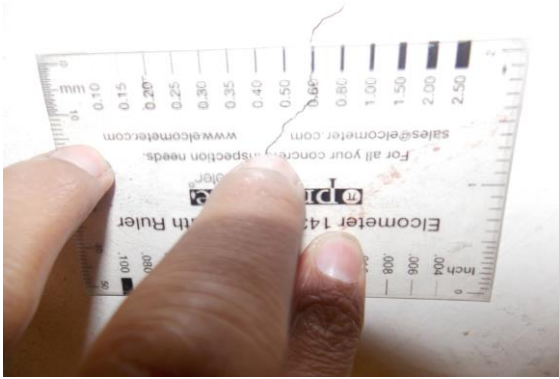
Photo 51A

Inclined Crack on Wall No. 3 of Gallery 2, Part A2 Upper Ground Floor
Approx. Width = 0.6mm, Approx. Length = 1m. Distance from Wall No. 1 = 11.1m, Height from Floor = 0m.

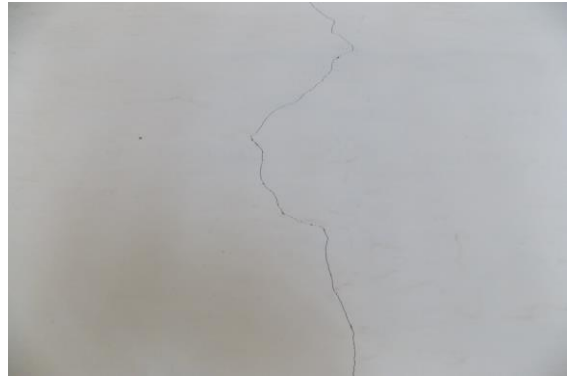
Photo 53

Inclined Crack on Wall No. 3 of Gallery 2, Part A2 Upper Ground Floor
Approx. Width = 0.4mm, Approx. Length = 2.2m. Distance from Wall No. 1 = 10.5m, Height from Floor = 0.5m.

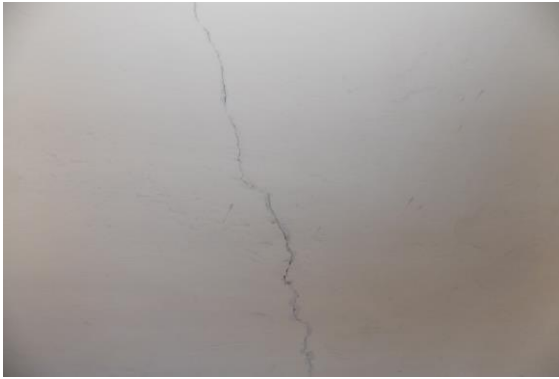
Photo 55

Inclined Crack on Wall No. 4 of Gallery 2, Part A2 Upper Ground Floor
Approx. Width = 0.5mm, Approx. Length = 1.5m. Distance from Wall No. 1 = 12.2m, Height from Floor = 0m.

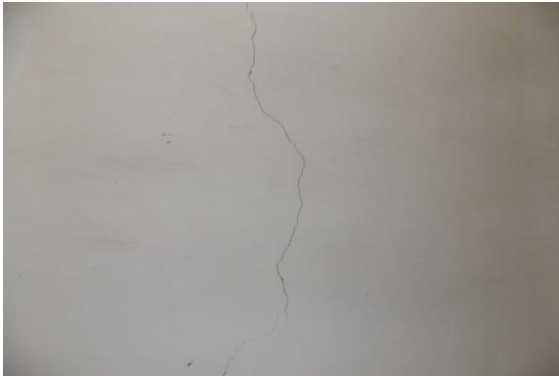
Photo 56

Inclined Crack on Wall No. 2 of Gallery 2, Part A2 Upper Ground Floor
Approx. Width = 0.8mm, Approx. Length = 3.3m. Distance from Wall No. 4 = 3.5m, Height from Floor = 0m.

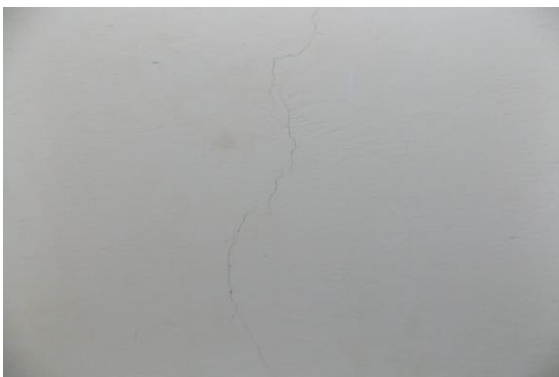
Photo 57

Inclined Crack on Wall No. 2 of Gallery 2, Part A2 Upper Ground Floor
Approx. Width = 0.35mm, Approx. Length = 3.5m. Distance from Wall No. 5 = 2.6m, Height from Floor = 0m.

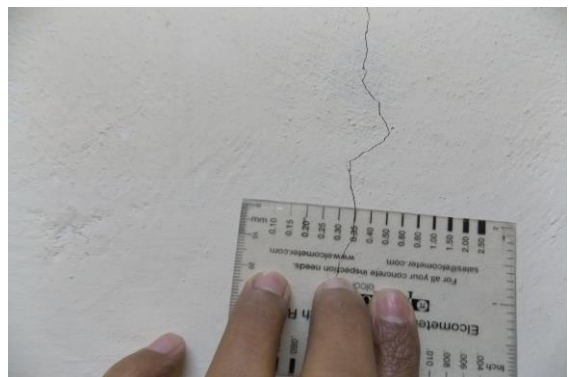
Photo 57A

Inclined Crack on Wall No. 2 of Gallery 2, Part A2 Upper Ground Floor
Approx. Width = 0.35mm, Approx. Length = 3.5m. Distance from Wall No. 5 = 2.6m, Height from Floor = 0m.

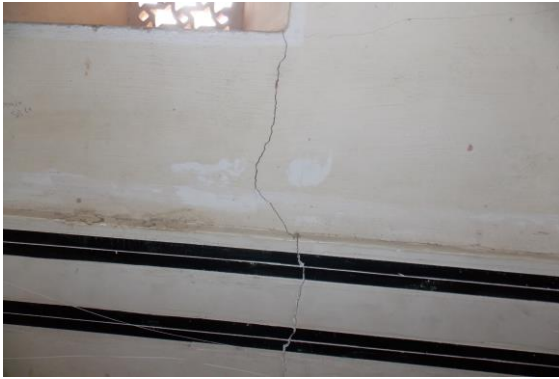
Photo 58

Inclined Crack on Wall No. 1 of Gallery 4, Part A2 Upper Ground Floor
Approx. Width = 0.8mm, Approx. Length = 1.3m. Distance from Wall No. 3 = 3.8m, Height from Floor = 0m.

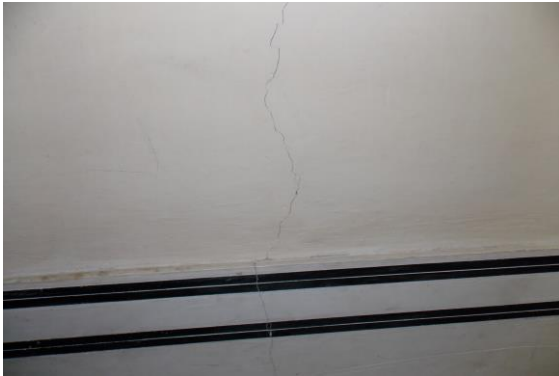
Photo 59

Inclined Crack on Wall No. 1 of Gallery 4, Part A2 Upper Ground Floor
Approx. Width = 0.5mm, Approx. Length = 3.5m. Distance from Wall No. 4 = 8.8m, Height from Floor = 0m.

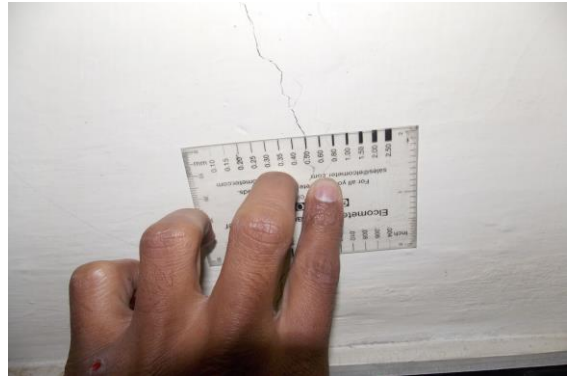
Photo 59A

Inclined Crack on Wall No. 1 of Gallery 4, Part A2 Upper Ground Floor
Approx. Width = 0.5mm, Approx. Length = 3.5m. Distance from Wall No. 4 = 8.8m, Height from Floor = 0m.

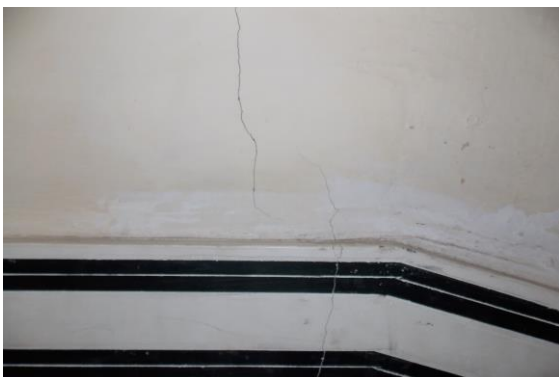
Photo 60

Inclined Crack on Wall No. 1 of Gallery 4, Part A2 Upper Ground Floor
Approx. Width = 0.4mm, Approx. Length = 2.3m. Distance from Wall No. 4 = 4.2m, Height from Floor = 0m.

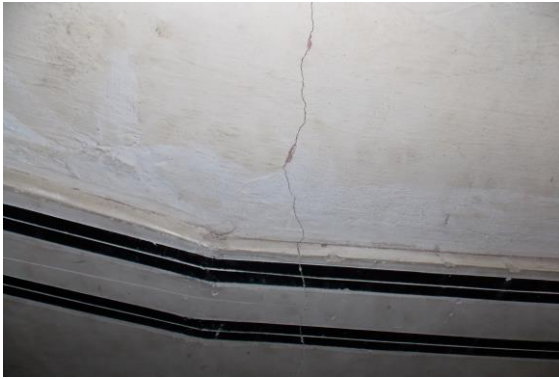
Photo 61

Inclined Crack on Wall No. 1 of Gallery 4, Part A2 Upper Ground Floor
Approx. Width = 0.35mm, Approx. Length = 2m. Distance from Wall No. 4 = 1.3m, Height from Floor = 0m.

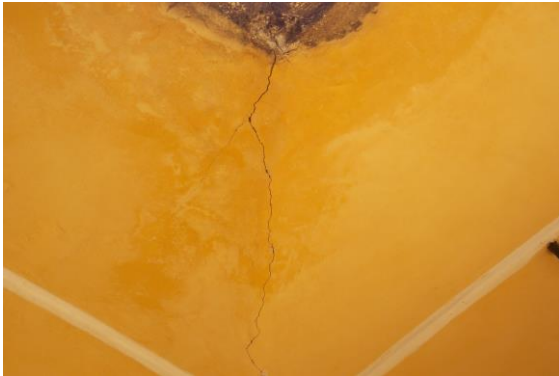
Photo 62

Inclined Crack on Sunshade, Part A2 Upper Ground Floor
Approx. Width = 1.2mm, Approx. Length = 4.3m.
Distance from Corner Wall No. 2 & 3 = 0m, Height from Floor = 0m.

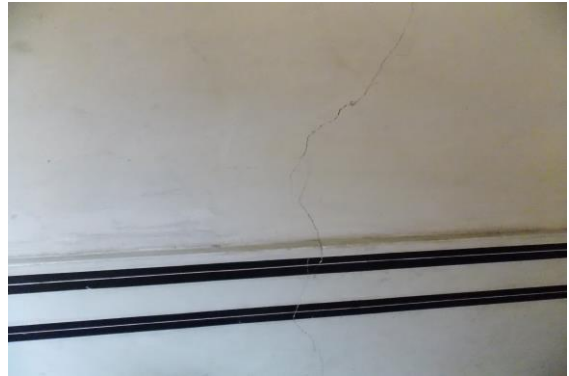
Photo 63

Inclined Crack on Wall No. 1 of Gallery 6, Part A2 Upper Ground Floor
Approx. Width = 0.3mm, Approx. Length = 2.5m. Distance from Wall No. 2 = 1.45m, Height from Floor = 0m.

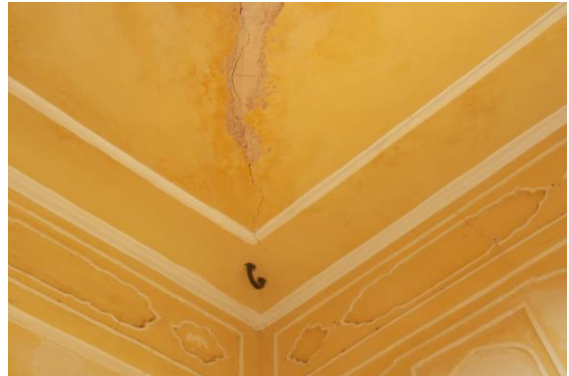
Photo 66

Inclined Crack on of Open Area Sunshade Corner, Part A2 Upper Ground Floor Approx. Width = 1mm, Approx. Length = 1.3m. Distance from Wall No. 2 & 3 Corner = 0m, Height from Floor = 3m.

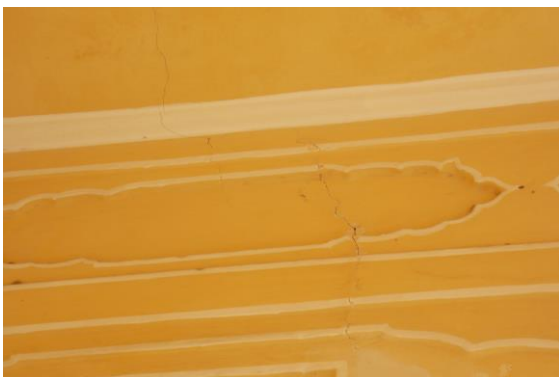
Photo 67

Inclined Crack on Wall No. 3 of Open Area, Part A2 Upper Ground Floor Approx. Width = 0.5mm, Approx. Length = 0.8m. Distance from Wall No. 2 = 0.75m, Height from Floor = 2.6m.

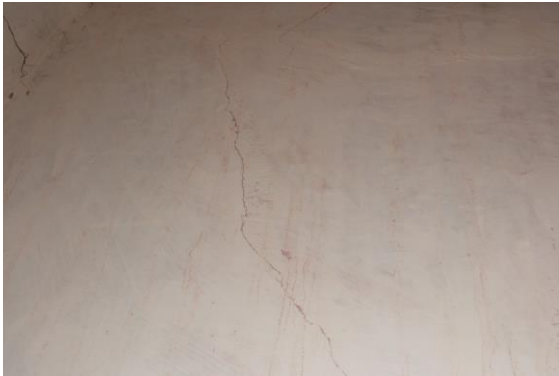
Photo 69

Inclined Crack on Wall No. 3 of Room No. 7, Part B2 Upper Ground Floor Approx. Width = 0.6mm, Approx. Length = 1.3m. Distance from Wall No. 2 = 0.5m, Height from Floor = 2.2m.

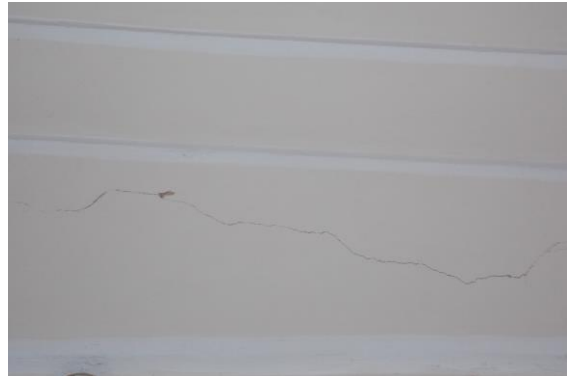
Photo 70

Inclined Crack on Wall No. 1 & Roof of Room No. 4, Part B2 Upper Ground Floor Approx. Width = 0.5mm, Approx. Length = 3.6m. Distance from Wall No. 2 = 0.25m, Height from Floor = 3m.

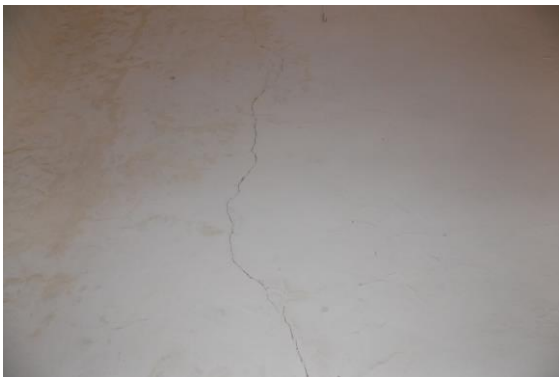
Photo 71

Inclined Crack on Wall No. 1 of Room No. 4, Part B2 Upper Ground Floor Approx. Width = 0.5mm, Approx. Length = 3.5m. Distance from Wall No. 3 = 0.25m, Height from Floor = 0m.

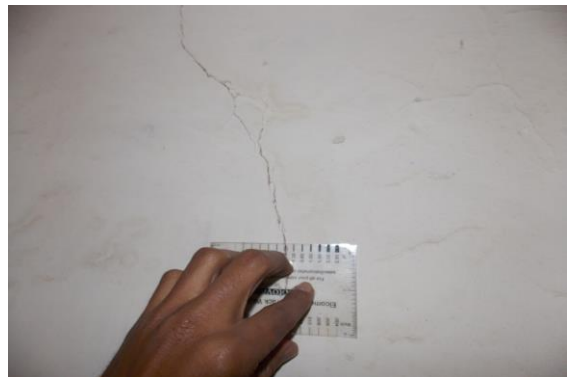
Photo 71A

Inclined Crack on Wall No. 1 of Room No. 4, Part B2 Upper Ground Floor Approx. Width = 0.5mm, Approx. Length = 3.5m. Distance from Wall No. 3 = 0.25m, Height from Floor = 0m.

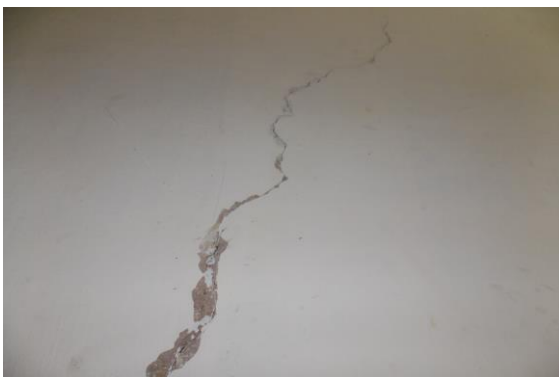
Photo 72

Inclined Crack on Wall No. 1 of Gallery 8, Part B2 Upper Ground Floor Approx. Width = 0.4mm, Approx. Length = 3.5m. Distance from Wall No. 4 = 4m, Height from Floor = 1.2m.

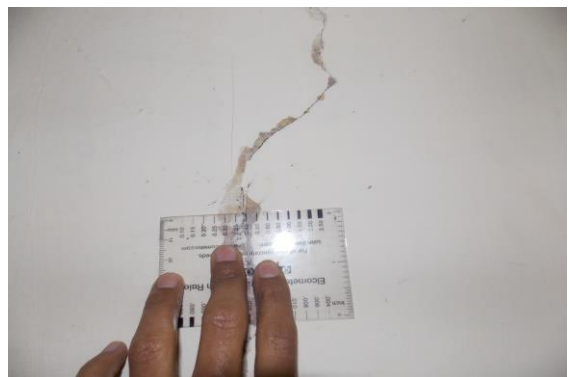
Photo 72A

Inclined Crack on Wall No. 1 of Gallery 8, Part B2 Upper Ground Floor Approx. Width = 0.4mm, Approx. Length = 3.5m. Distance from Wall No. 4 = 4m, Height from Floor = 1.2m.

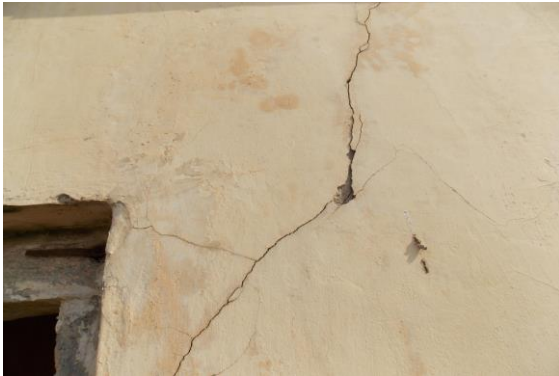
Photo 73

Inclined Crack on Wall No. 3 of Open Area 2, Terrace of (A2+B2) Open Area Approx. Width = 0.6mm, Approx. Length = 0.5m. Distance from Wall No. 1 = 5m, Height from Floor = 2m.

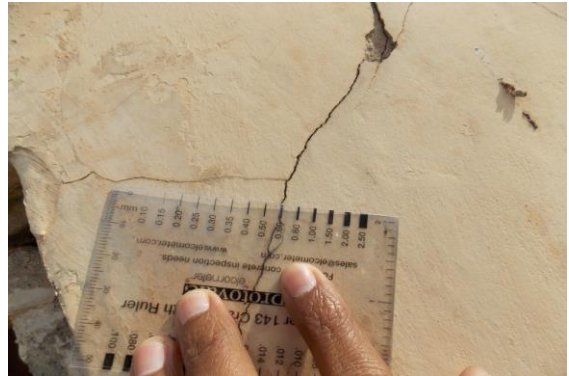
Photo 73A

Inclined Crack on Wall No. 3 of Open Area 2, Terrace of (A2+B2) Open Area Approx. Width = 0.6mm, Approx. Length = 0.5m. Distance from Wall No. 1 = 5m, Height from Floor = 2m.

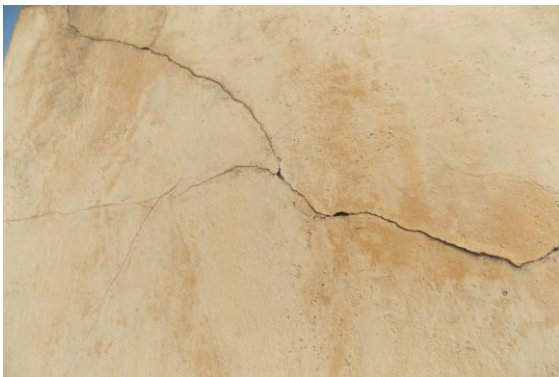
Photo 74

Inclined Crack on Wall No. 3 of Open Area 2, Terrace of (A2+B2) Open Area Approx. Width = 0.35mm, Approx. Length = 0.4m. Distance from Wall No. 1 = 6m, Height from Floor = 2m.

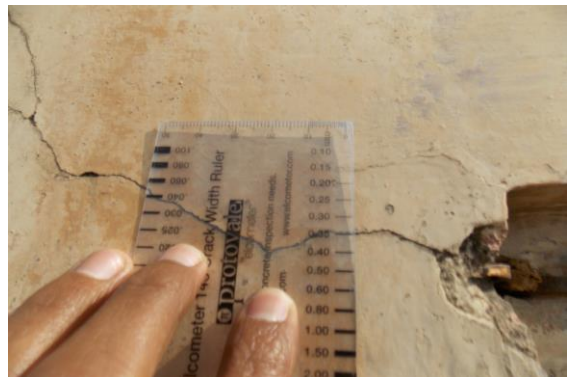
Photo 74A

Inclined Crack on Wall No. 3 of Open Area 2, Terrace of (A2+B2) Open Area Approx. Width = 0.35mm, Approx. Length = 0.4m. Distance from Wall No. 1 = 6m, Height from Floor = 2m.

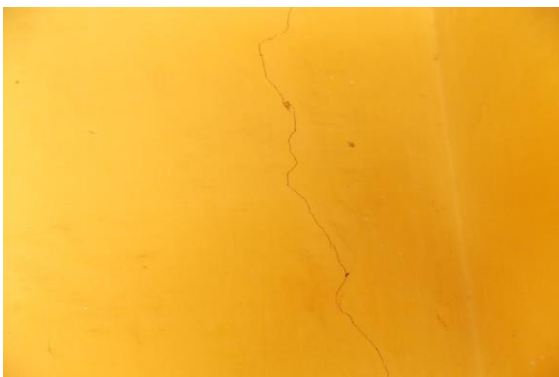
Photo 75

Inclined Crack on Wall No. 4 of Vranda 1, Terrace of (A2+B2) Open Area Approx. Width = 1mm, Approx. Length = 1.5m. Distance from Wall No. 2 = 0.2m, Height from Floor = 1m.

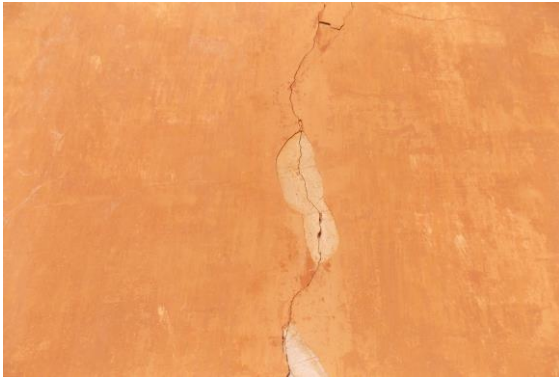
Photo 76

Inclined Crack on Wall No. 4 of Open Area 1, Terrace of (A2+B2) Open Area Approx. Width = 0.5mm, Approx. Length = 5m. Distance from Wall No. 1 = 5.5m, Height from Floor = 1m.

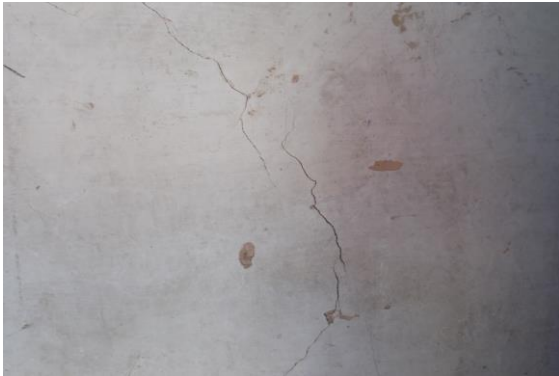
Photo 77

Inclined Crack on Wall No. 4 of Room No. 4, Terrace of (A2+B2) Open Area Approx. Width = 0.6mm, Approx. Length = 1m. Distance from Wall No. 1 = 1.7m, Height from Floor = 0m.

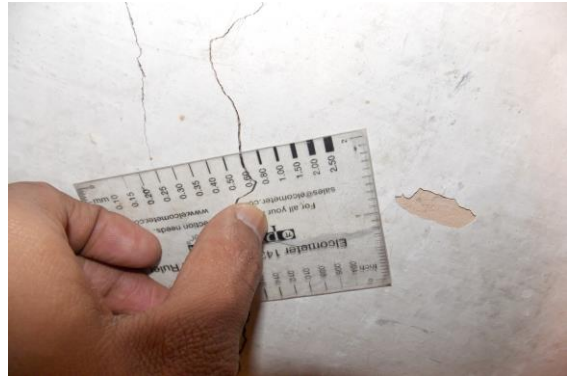
Photo 77A

Inclined Crack on Wall No. 4 of Room No. 4, Terrace of (A2+B2) Open Area Approx. Width = 0.6mm, Approx. Length = 1m. Distance from Wall No. 1 = 1.7m, Height from Floor = 0m.

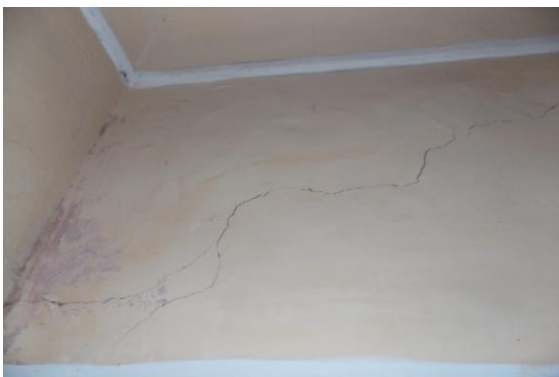
Photo 78

Inclined Crack on Roof of Gallery 2 beam, Terrace of (A2+B2) Open Area Approx. Width = 0.4mm, Approx. Length = 0.9m. Distance from Wall No. 3 = 0m, Height from Floor = 1.9m.

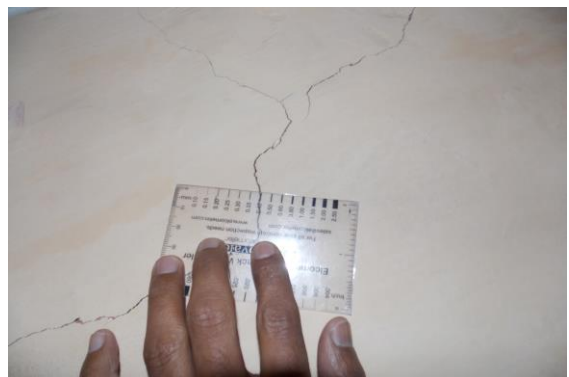
Photo 78A

Inclined Crack on Roof of Gallery 2 beam, Terrace of (A2+B2) Open Area Approx. Width = 0.4mm, Approx. Length = 0.9m. Distance from Wall No. 3 = 0m, Height from Floor = 1.9m.

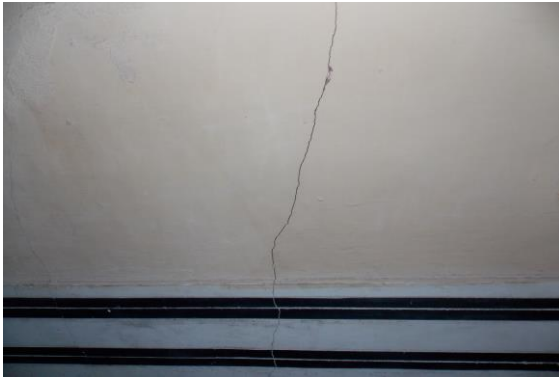
Photo 79

Inclined Crack on Wall No. 4 of Gallery 2, Terrace of (A2+B2) Open Area Approx. Width = 0.6mm, Approx. Length = 2m. Distance from Wall No. 2 = 4m, Height from Floor = 0m.

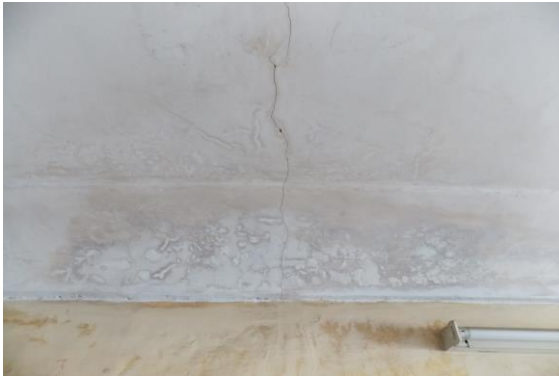
Photo 80

Inclined Crack on Wall No. 4 & Roof of Ope Gallery 1, Terrace of (A2+B2) Open Area Approx. Width = 0.4mm, Approx. Length = 2m. Distance from Wall No. 2 = 3m, Height from Floor = 2.1m.

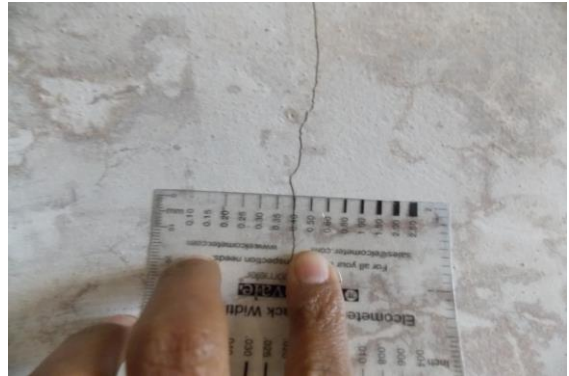
Photo 80A

Inclined Crack on Wall No. 4 & Roof of Ope Gallery 1, Terrace of (A2+B2) Open Area Approx. Width = 0.4mm, Approx. Length = 2m. Distance from Wall No. 2 = 3m, Height from Floor = 2.1m.

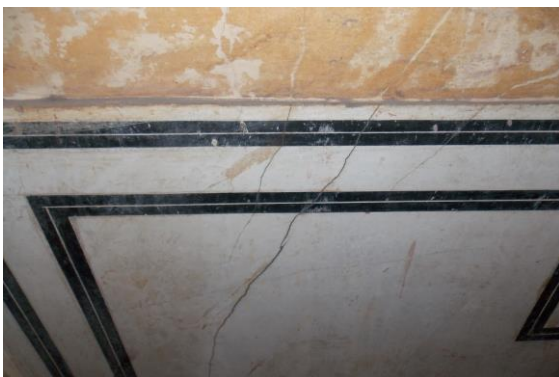
Photo 81

Inclined Crack on Wall No. 4 of Ope Gallery 1, Terrace of (A2+B2) Open Area Approx. Width = 0.8mm, Approx. Length = 2.5m. Distance from Wall No. 1 = 3m, Height from Floor = 0m.

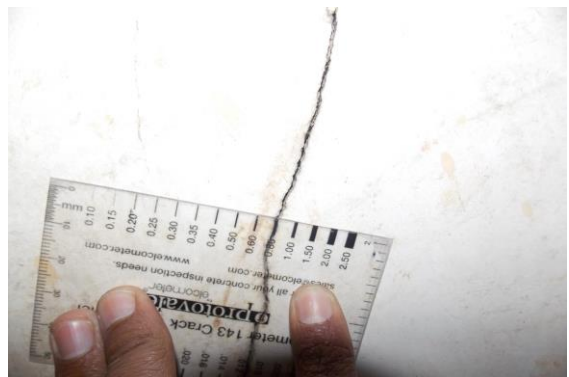
Photo 81A

Inclined Crack on Wall No. 4 of Ope Gallery 1, Terrace of (A2+B2) Open Area Approx. Width = 0.8mm, Approx. Length = 2.5m. Distance from Wall No. 1 = 3m, Height from Floor = 0m.

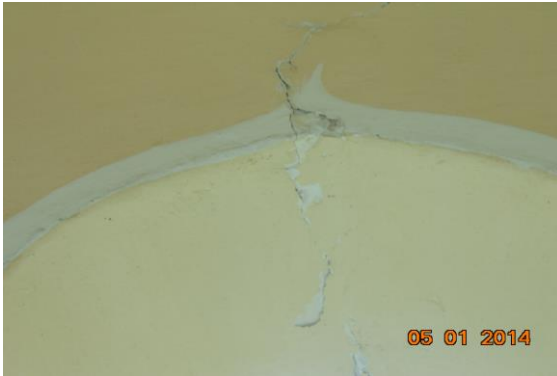
Photo 82

Inclined Crack on Wall No. 3 of Vranda 17, Part B1 Upper Ground Floor
Approx. Width = 0.4mm, Approx. Length = 0.5m. Distance from Wall No. 1 = 0.6m, Height from Floor = 2.2m.

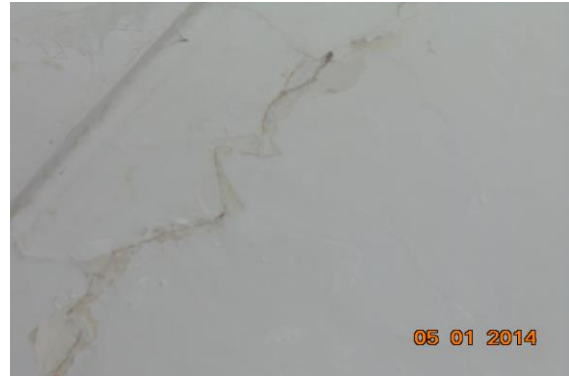
Photo 83

Inclined Crack on Roof of Room No. 6, Part B1 Upper Ground Floor
Approx. Width = 5mm, Approx. Length = 3m.
Distance from Wall No. 4 = 0m, Height from Floor = 4m.

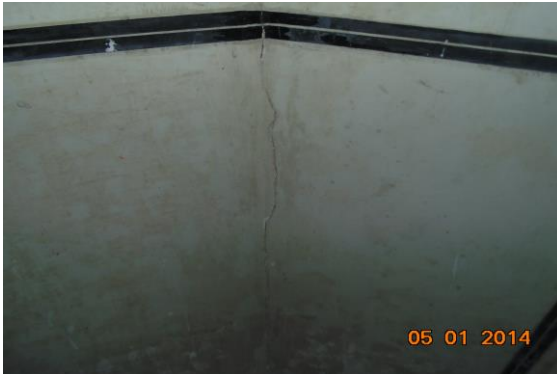
Photo 84

Vertical Crack on Wall No. 4 of Hall No. 1,
Approx. Width = 0.8mm, Approx. Length = 1m.
Distance from Wall No. 1 = 2.5m, Height from Floor = 0m.

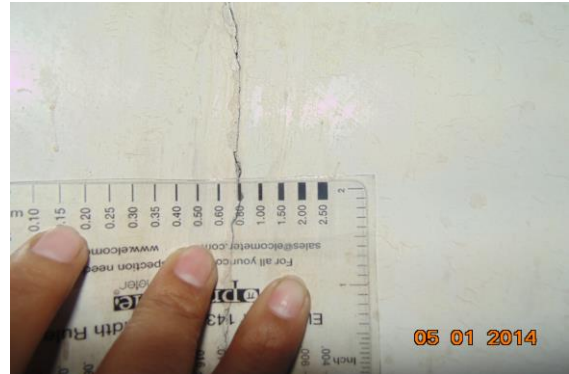
Photo 84A

Vertical Crack on Wall No. 4 of Hall No. 1,
Approx. Width = 0.8mm, Approx. Length = 1m.
Distance from Wall No. 1 = 2.5m, Height from Floor = 0m.

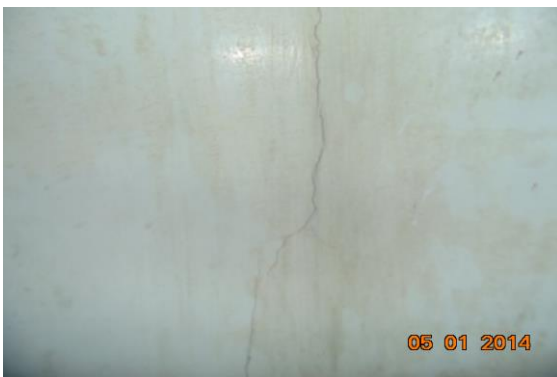
Photo 85

Inclined Crack on Wall No. 4 of Hall No. 1, Approx. Width = 0.6mm,
Approx. Length = 1m. Distance from Wall No. 1 = 2m, Height from Floor = 0m.

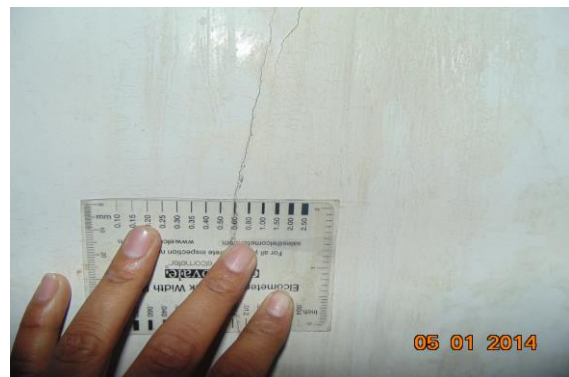
Photo 85A

Inclined Crack on Wall No. 4 of Hall No. 1, Approx. Width = 0.6mm,
Approx. Length = 1m. Distance from Wall No. 1 = 2m, Height from Floor = 0m.

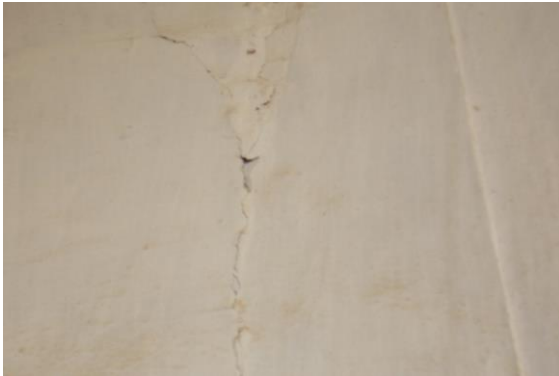
Photo 86

Peeling of Plaster on Wall No. 2 of Gate of Part A1 Upper Ground Floor

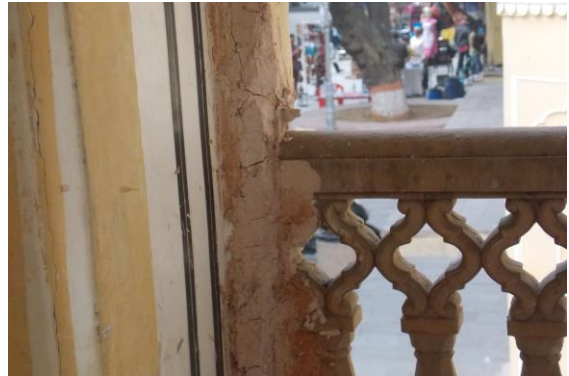
Photo 87

Damaged Portion on Wall No. 4 of Minaret 1 of Part A1 Upper Ground Floor

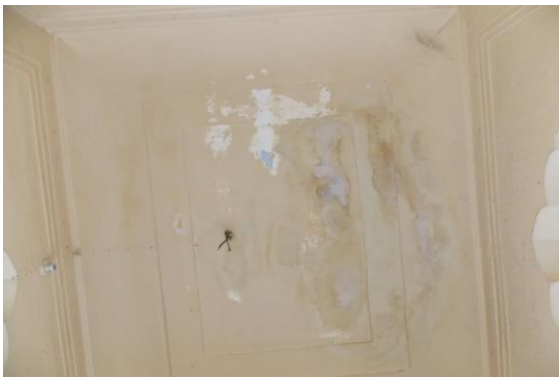
Photo 88

Dampness/Seepage on Roof of Gate of Part A1 Upper Ground Floor

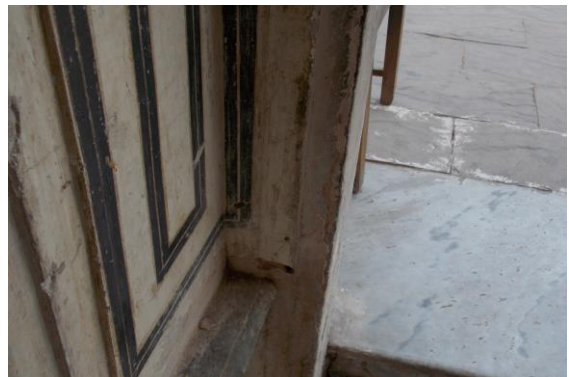
Photo 89

Peeling of Plaster on Wall No. 4 of Gate of Part A1 Upper Ground Floor

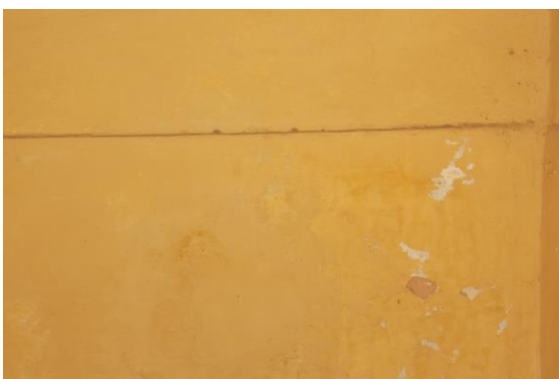
Photo 90

Peeling of Plaster on Wall No. 4 of Room No. 1 of Part A1 Upper Ground Floor

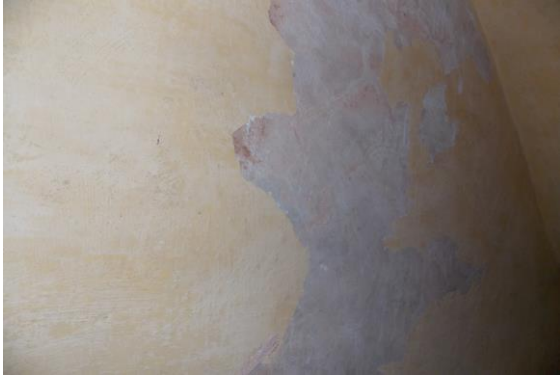
Photo 92
Peeling of Plaster on Wall No. 4 of Room No. 3 of Part A1 Upper Ground Floor

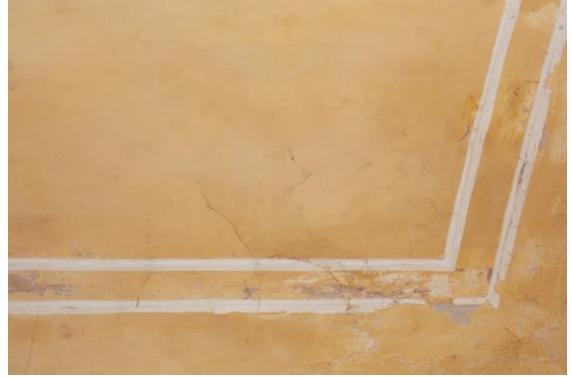
Photo 93
Dampness/Seepage on Roof of Room No. 4 of Part A1 Upper Ground Floor

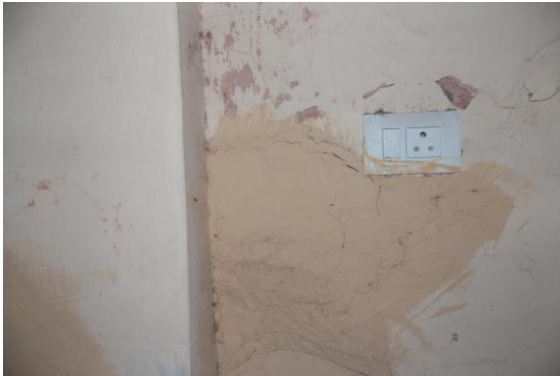
Photo 94
Damaged Portion on Wall No. 2 of Stair Case 4 of Part A1 Upper Ground Floor

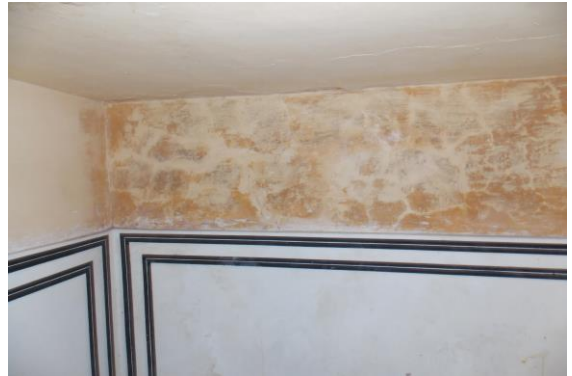
Photo 95
Dampness/Seepage on Wall No. 4 of Room No. 10 of Part A1 Upper Ground Floor

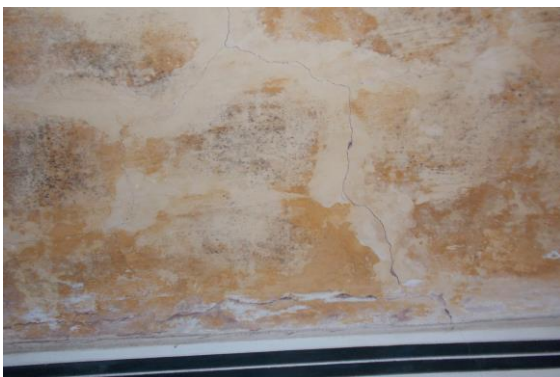
Photo 96
Peeling of Plaster on Wall No. 4 of Room No. 10 of Part A1 Upper Ground Floor

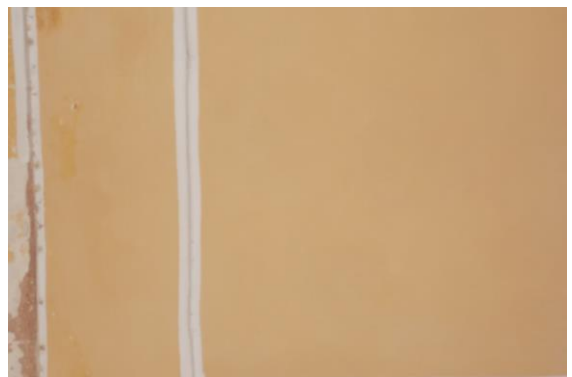
Photo 97
Peeling of Plaster on Roof of Room No. 10 of Part A1 Upper Ground Floor

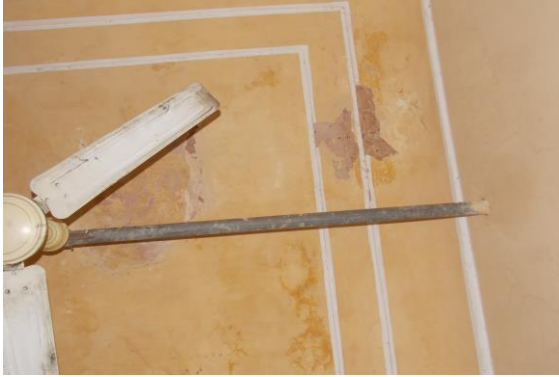
Photo 98

Dampness/Seepage on Roof of Room No. 11 of Part A1 Upper Ground Floor

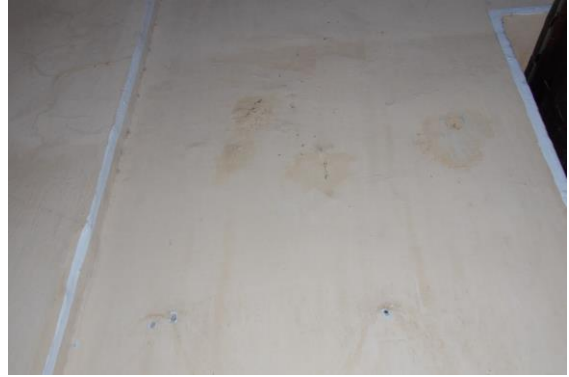
Photo 99

Dampness/Seepage on Wall No. 3 of Room No. 11 of Part A1 Upper Ground Floor

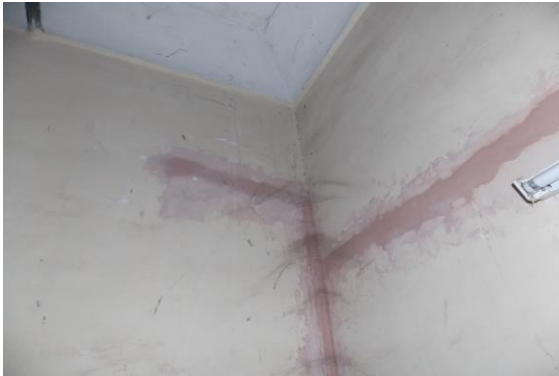
Photo 100

Damaged Portion on Wall No. 2 & 4 of Room No. 13 of Part A1 Upper Ground Floor

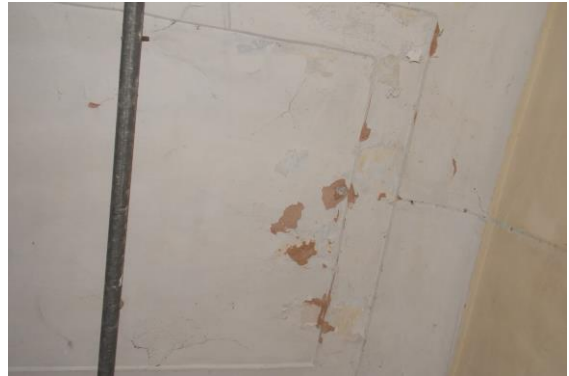
Photo 101

Dampness/Seepage on Roof of Room No. 13 of Part A1 Upper Ground Floor

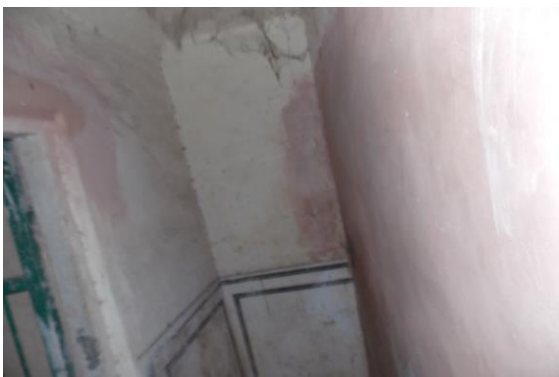
Photo 102

Damaged Portion on Wall No. 2 & 4 of Room No. 14 of Part A1 Upper Ground Floor

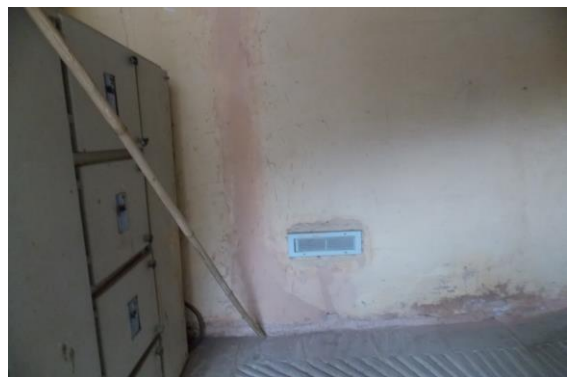
Photo 103

Peeling of Plaster on Wall No. 4 of Stair Case 5 of Part A1 Upper Ground Floor

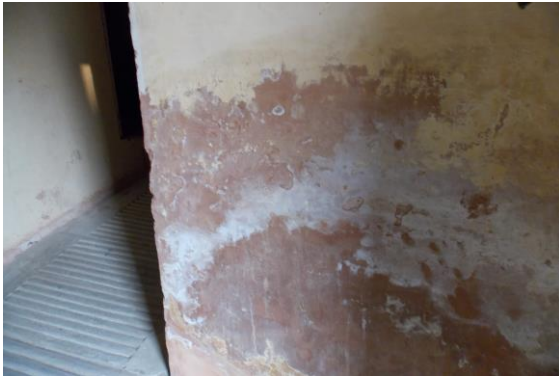
Photo 104
Dampness/Seepage on Wall No. 3 & 4 of Room No. 15 of Part A1
Upper Ground Floor

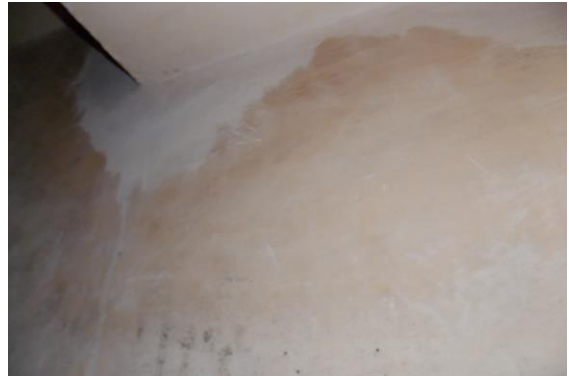
Photo 105
Dampness/Seepage on Wall No. 2 of Stair Case of Part A1 Upper
Ground Floor
