Pre Building Condition Survey Report

Name and Address of Structure :	Badi Chopar Station Area
---------------------------------	--------------------------

Name of the Project	Contract JMRC-UG1B “Design and Construction of Tunnel between Chandpole and Badi Chouper and reverse line by Shield TBM, Underground Metro Stations at Choti Chouper and Badi Chouper by Cut and Cover Methods on East West Corridor of Jaipur Metro Rail Corporation Limited .”	
Owner :

Pre - Condition Building Survey for Construction of Underground Stations from Chandpole to Bari Chouper and reversal line

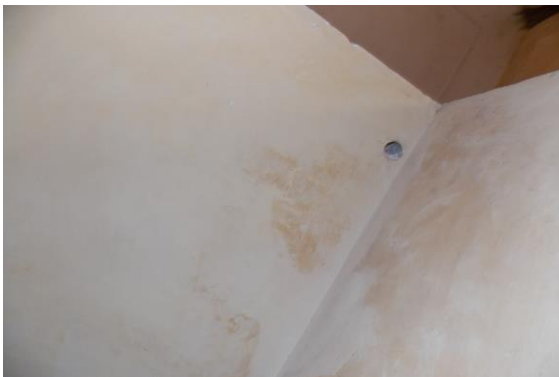
Photo 106
Dampness/Seepage on Roof of Stair Case of Part A1 Upper Ground
Floor

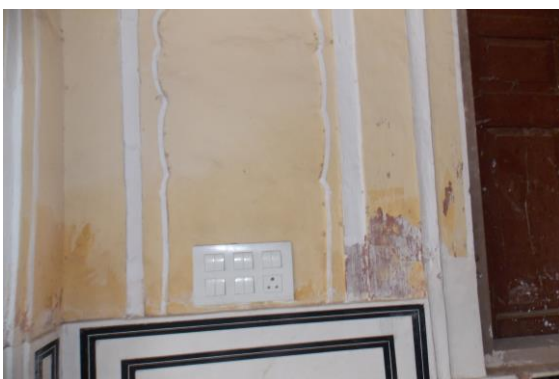
Photo 108
Peeling of Plaster on Wall No. 1 of Vrandha 4 of Part A1 Upper Ground
Floor

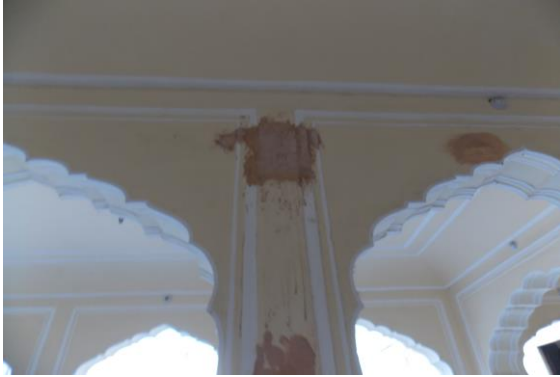
Photo 110

Damaged Portion on Wall No. 3 of Vrandha 4 of Part A1 Upper Ground Floor

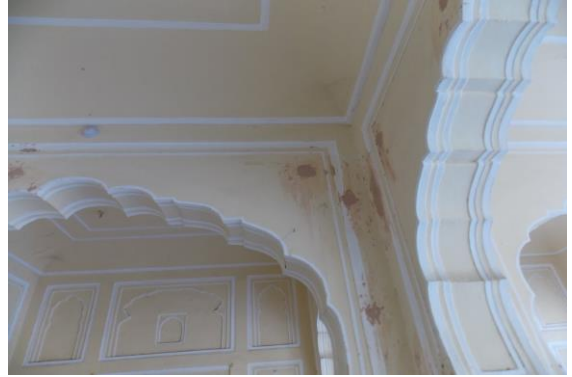
Photo 111

Damaged Portion on Wall No. 2 of Vrandha 4 of Part A1 Upper Ground Floor

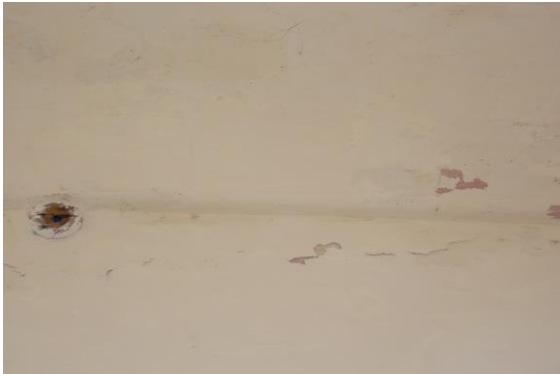
Photo 112

Peeling of Plaster on Wall No. 4 of Room No. 17 of Part A1 Upper Ground Floor

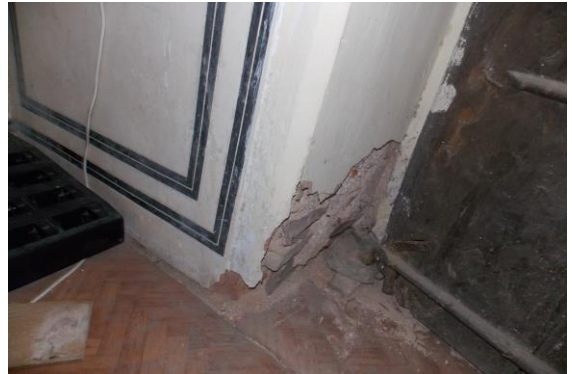
Photo 113

Peeling of Plaster on Wall No. 2 of Hawa Mahal of Part A1 Upper Ground Floor

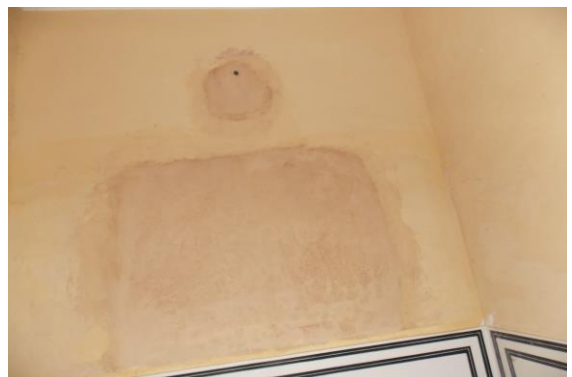
Photo 115

Damaged Portion on Wall No. 1 of Room No. 16 of Part A1 Upper Ground Floor

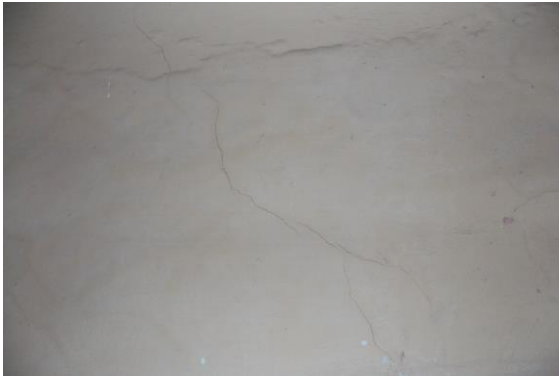
Photo 116

Plaster Crack on Wall No. 3 of Room No. 16 of Part A1 Upper Ground Floor

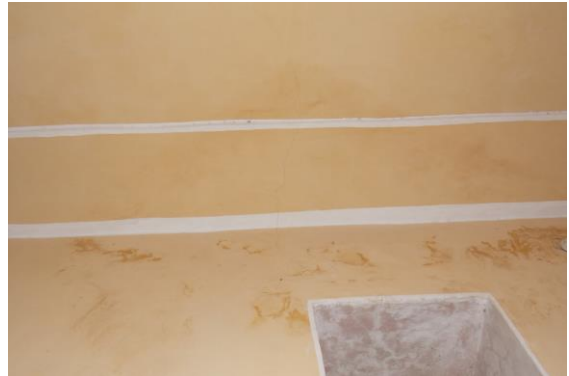
Photo 117

Dampness/Seepage on Roof & Wall No. 4 of Passage 1 of Part A1 Upper Ground Floor

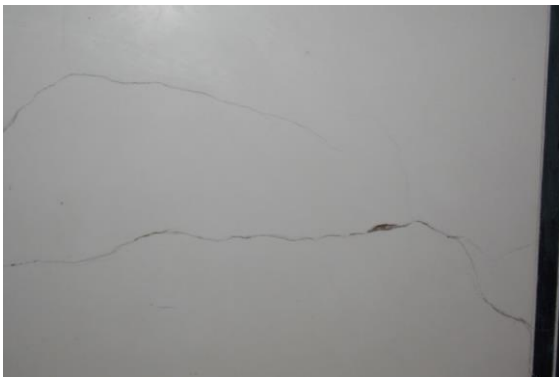
Photo 118

Plaster Crack on Wall No. 2 of Room No. 16 of Part A1 Upper Ground Floor

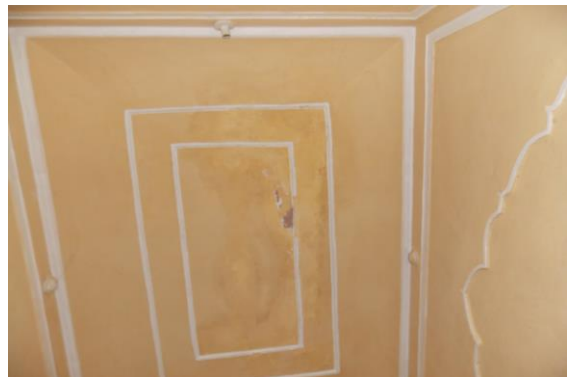
Photo 119

Dampness/Seepage on Roof of Room No. 15 of Part A1 Upper Ground Floor

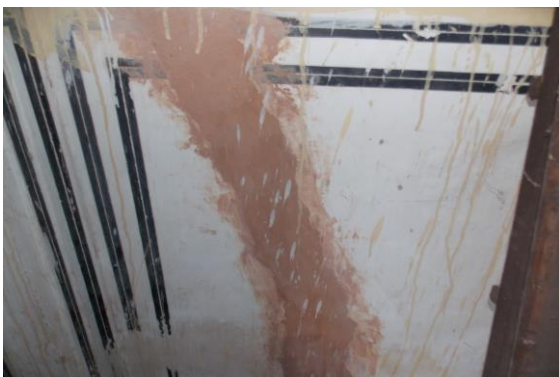
Photo 120

Damaged Portion on Wall No. 1 of Room No. 15 of Part A1 Upper Ground Floor

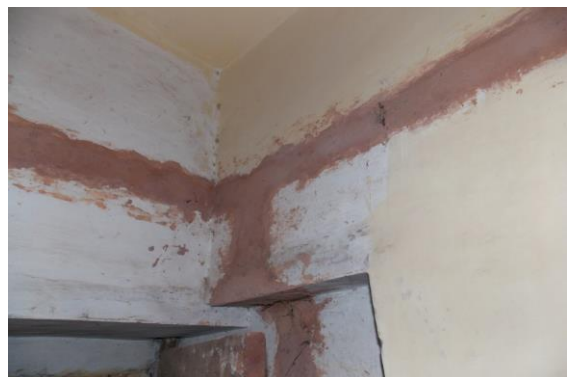
Photo 121

Damaged Portion on Wall No. 1 & 3 of Stair Case 3 of Part A1 Upper Ground Floor

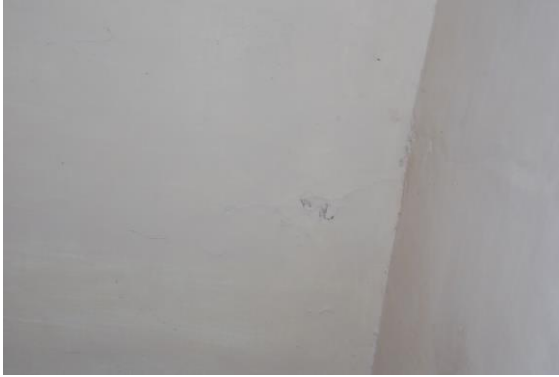
Photo 122

Peeling of Plaster on Roof of Stair Case 3 of Part A1 Upper Ground Floor

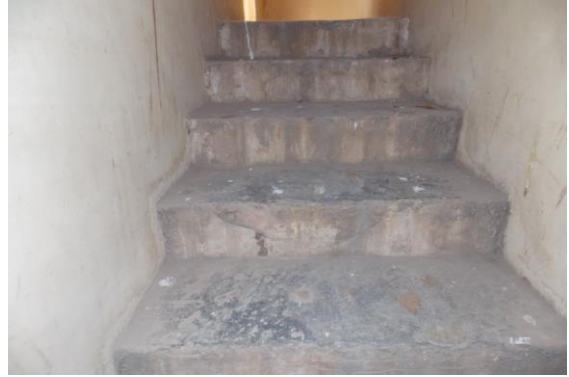
Photo 123

Peeling of Plaster on Steps of Stair Case 3 of Part A1 Upper Ground Floor

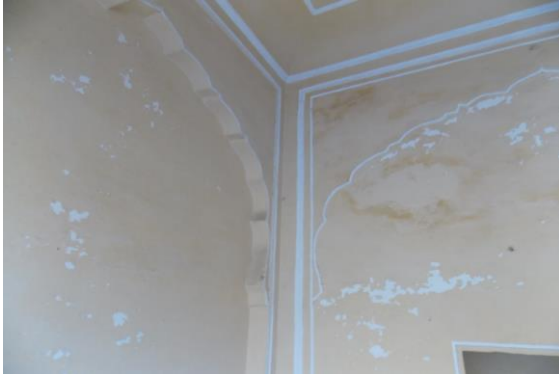
Photo 124

Dampness/Seepage on Wall No. 1 & 4 of Vrandha 2 of Part A1 Upper Ground Floor

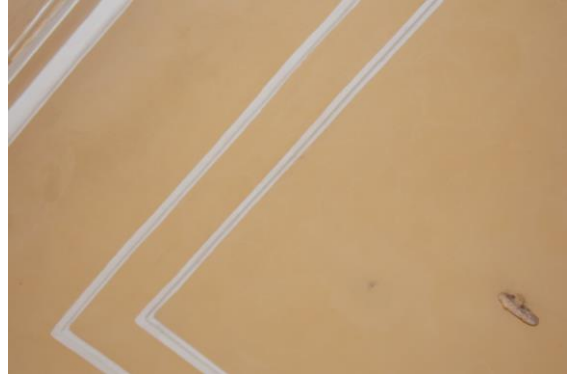
Photo 125

Dampness/Seepage on Roof of Vrandha 2 of Part A1 Upper Ground Floor

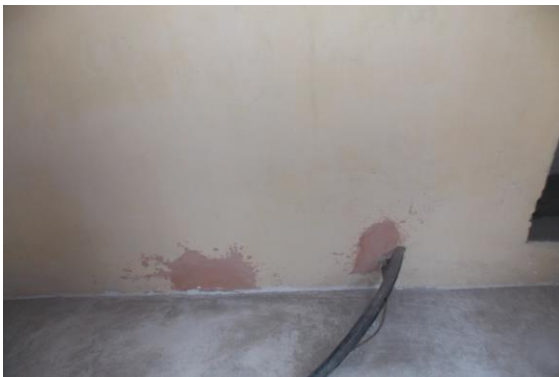
Photo 126

Damaged Portion on Wall No. 4 of Room No. 7 of Part A1 Upper Ground Floor

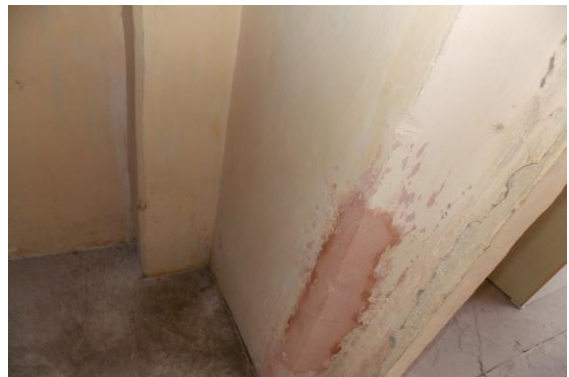
Photo 127

Damaged Portion on Wall No. 3 of Room No. 7 of Part A1 Upper Ground Floor

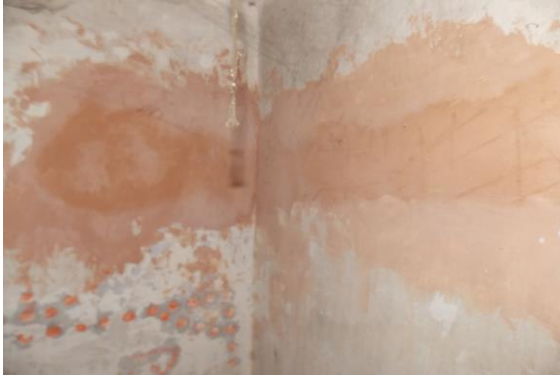
Photo 128

Damaged Portion on Wall No. 2 & 4 of Room No. 8 of Part A1 Upper Ground Floor

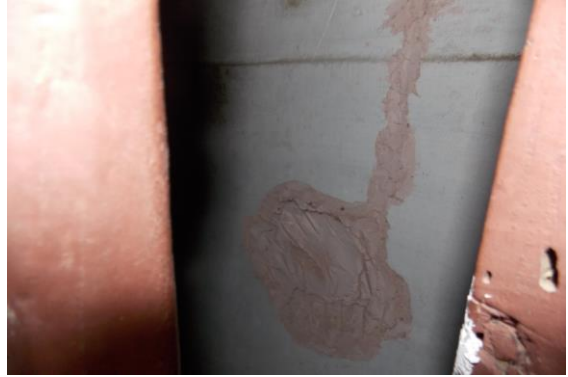
Photo 129

Damaged Portion on Wall No. 2 of Room No. 6 of Part A1 Upper Ground Floor

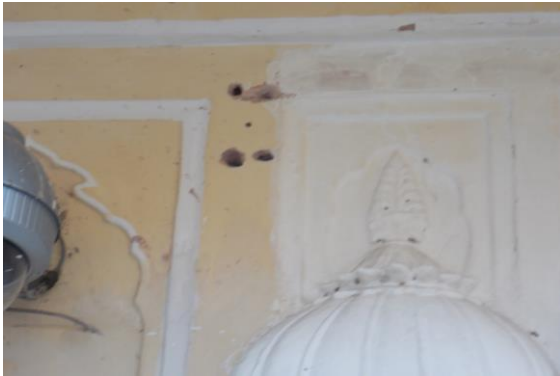
Photo 130

Peeling of Plaster on Wall No. 3 of Open Area of Part A1 Upper Ground Floor

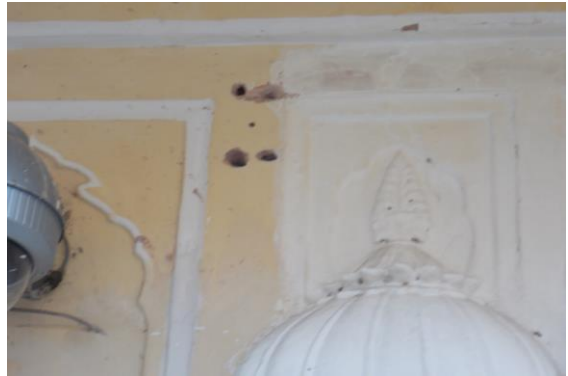
Photo 131

Damaged Portion on Wall No. 3 of Open Area of Part A1 Upper Ground Floor

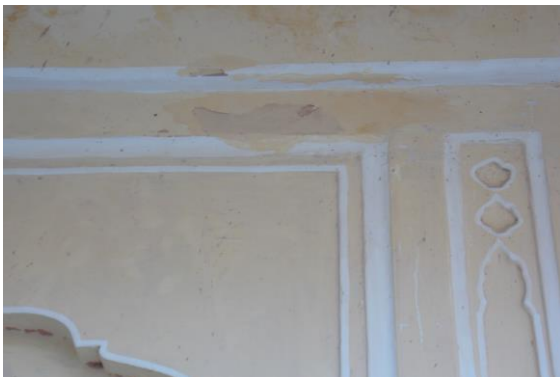
Photo 132

Damaged Portion on Wall No. 3 of Open Area of Part A1 Upper Ground Floor

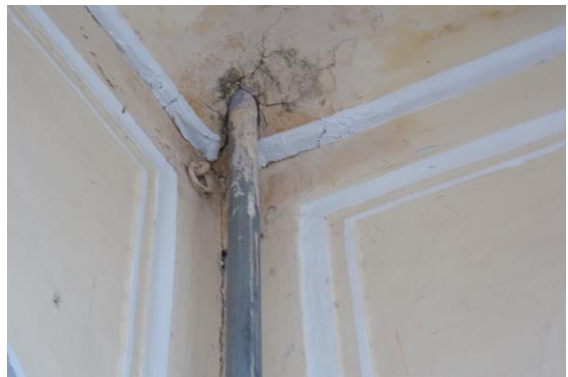
Photo 133

Peeling of Plaster on Wall No. 3 of Open Area of Part A1 Upper Ground Floor

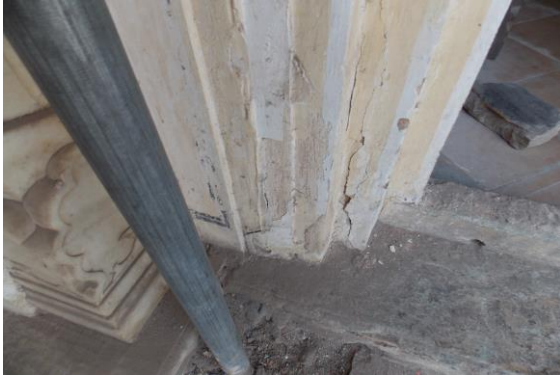
Photo 134

Peeling of Plaster on Wall No. 3 of Open Area of Part A1 Upper Ground Floor

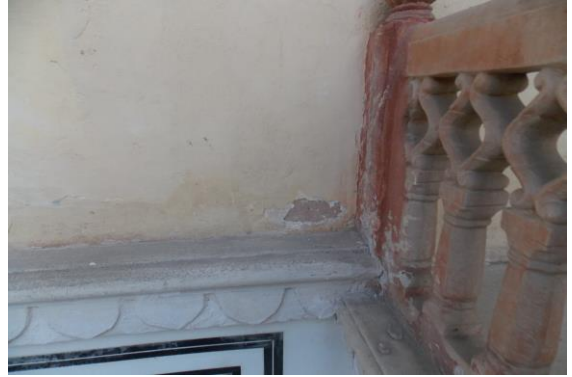
Photo 135

Peeling of Plaster on Wall No. 4 of Open Area of Part A1 Upper Ground Floor

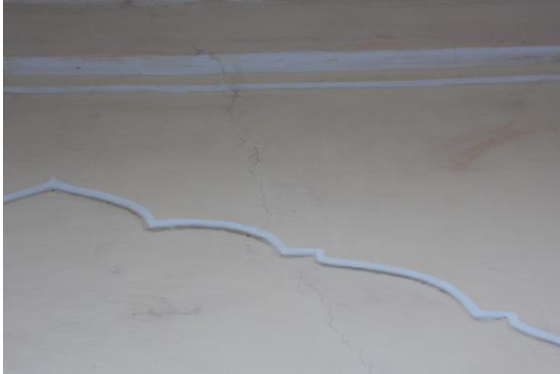
Photo 136

Plaster Crack on Wall No. 1 of Open Area of Part A1 Upper Ground Floor

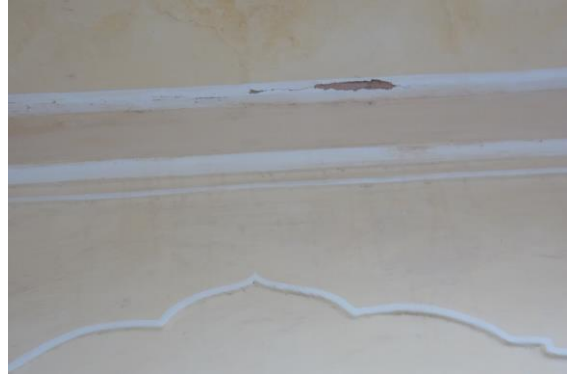
Photo 137

Peeling of Plaster on Wall No. 1 of Open Area of Part A1 Upper Ground Floor

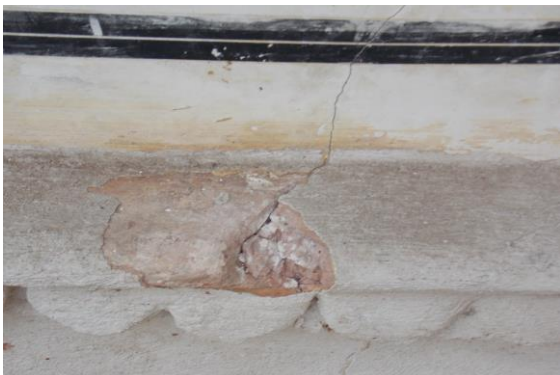
Photo 138

Peeling of Plaster on Wall No. 3 of Open Area of Part A1 Upper Ground Floor

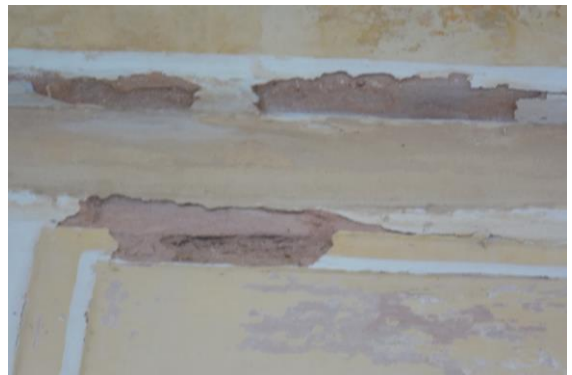
Photo 139

Peeling of Plaster on Wall No. 3 of Open Area of Part A1 Upper Ground Floor

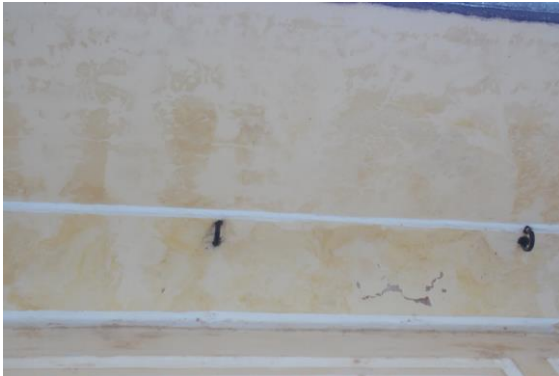
Photo 140

Dampness/Seepage on Wall No. 3 & Sunshade of Open Area Part 1 of Part A1 Upper Ground Floor

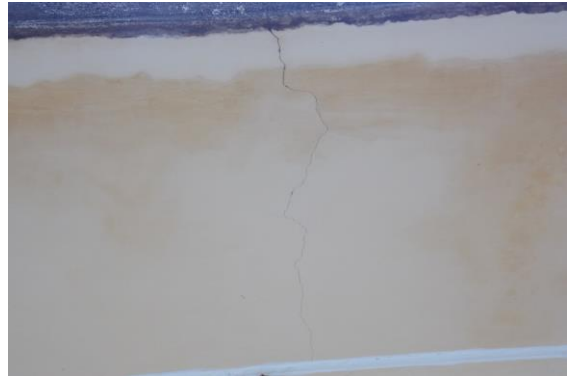
Photo 141

Dampness/Seepage on Wall No. 2 & Sunshade of Open Area Part A 1 of Part A1 Upper Ground Floor

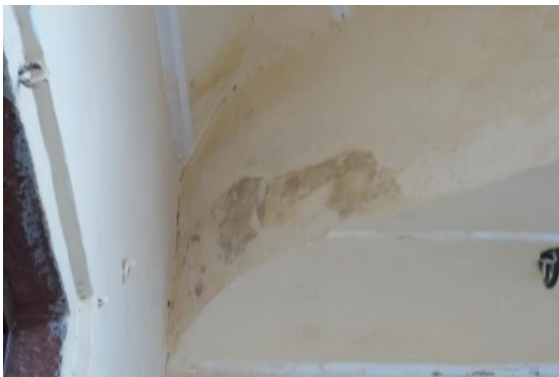
Photo 142

Dampness/Seepage on Wall No. 2 & 4 Corner Sky open Part A1 of Part A1 Upper Ground Floor

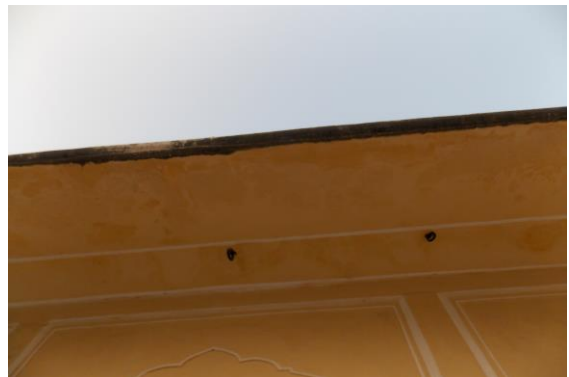
Photo 143

Dampness/Seepage on Wall No. 1 & Sunshade of Open Area Part A 1 of Part A1 Upper Ground Floor

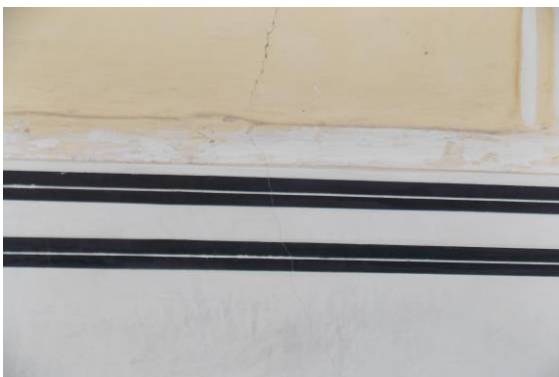
Photo 144

Plaster Crack on Wall No. 1 & Sunshade of Open Area Part A 1 of Part A1 Upper Ground Floor

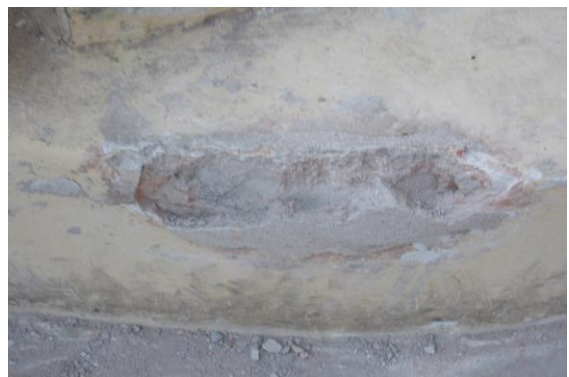
Photo 145

Peeling of Plaster on Wall No. 2 of Outer wall of well of Part A1 Upper Ground Floor

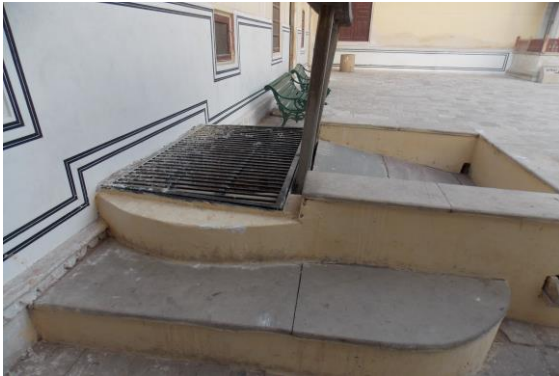
Photo 146

Peeling of Plaster on All Wall of Internal wall of Well of Part A1 Upper Ground Floor

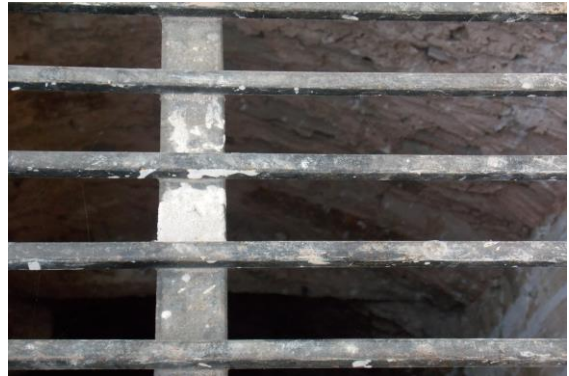
Photo 147

Damaged Portion on All Wall of Inside of Well of Part A1 Upper Ground Floor

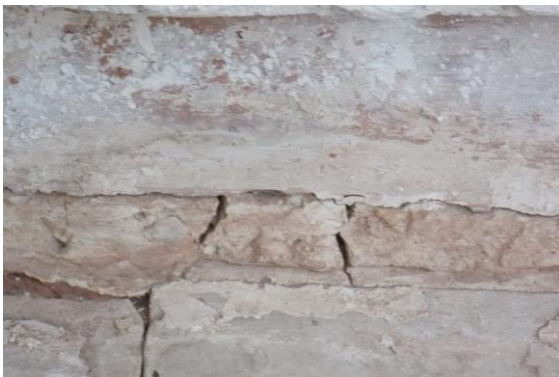
Photo 148

Damaged Portion on Wall No. 1 of of Part A1 Upper Ground Floor

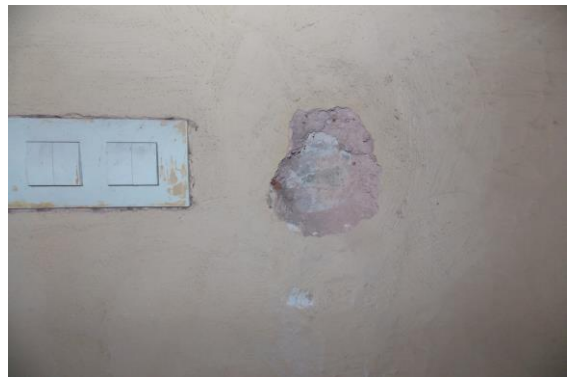
Photo 149

Peeling of Plaster on of Main gate of Part A1 Upper Ground Floor

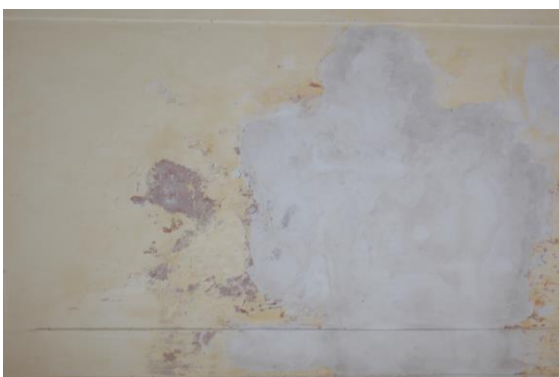
Photo 150

Peeling of Plaster on Roof of Main gate of Part A2 Upper Ground Floor

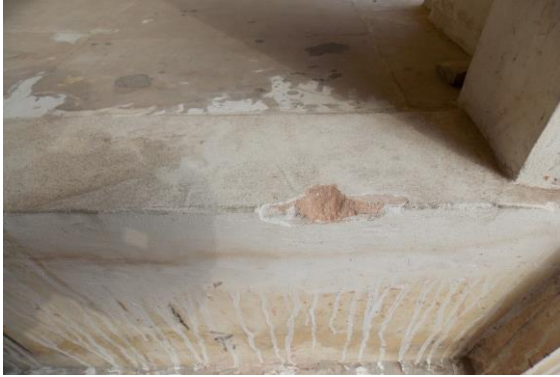
Photo 152

Peeling of Plaster on Wall No. 1 of Main gate of Part A2 Upper Ground Floor

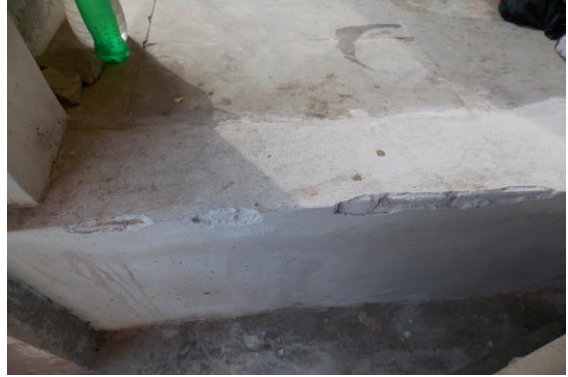
Photo 153

Peeling of Plaster on Wall No. 2 of Main gate of Part A2 Upper Ground Floor

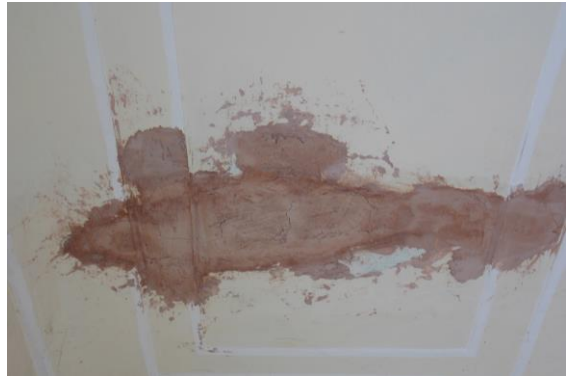
Photo 154

Peeling of Plaster on Wall No. 4 of Main gate of Part A2 Upper Ground Floor

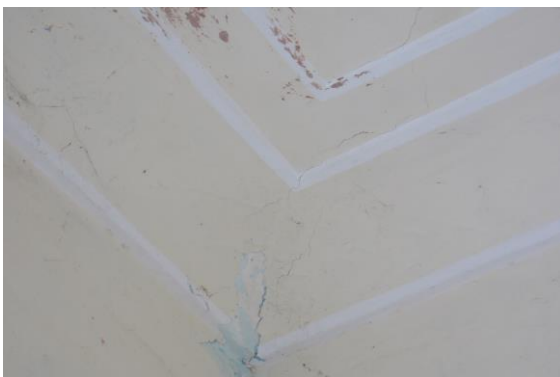
Photo 155

Damaged Portion on Roof of Vrandha 1 of Part A2 Upper Ground Floor

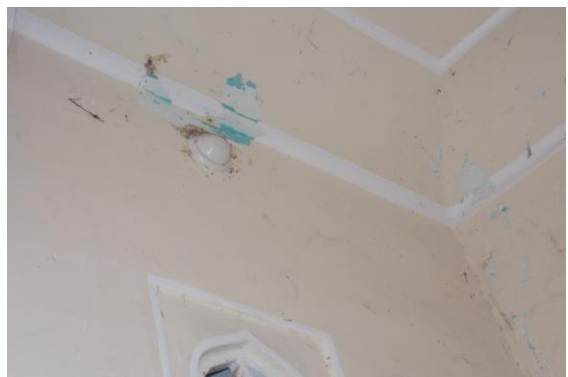
Photo 156

Plaster Crack on Roof & Wall No. 2 of Vrandha 3 of Part A2 Upper Ground Floor

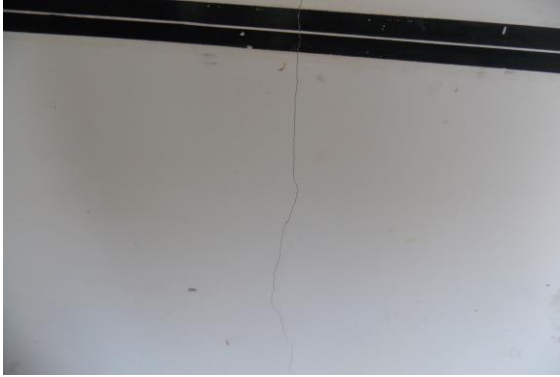
Photo 157

Peeling of Plaster on Wall No. 2 & 4 of Vrandha 3 of Part A2 Upper Ground Floor

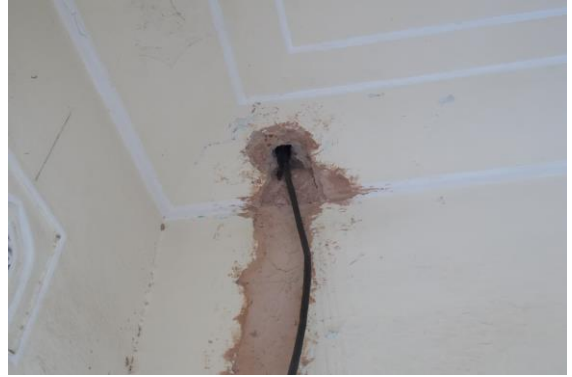
Photo 158
Plaster Crack on Wall No. 4 of Vrandha 3 of Part A2 Upper Ground Floor

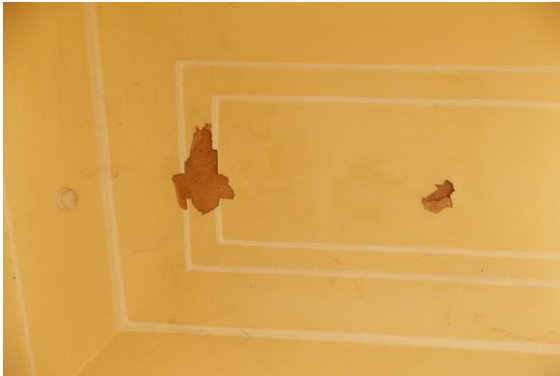
Photo 159
Damaged Portion on Roof & Wall No. 1 of Vrandha 3 of Part A2 Upper Ground Floor

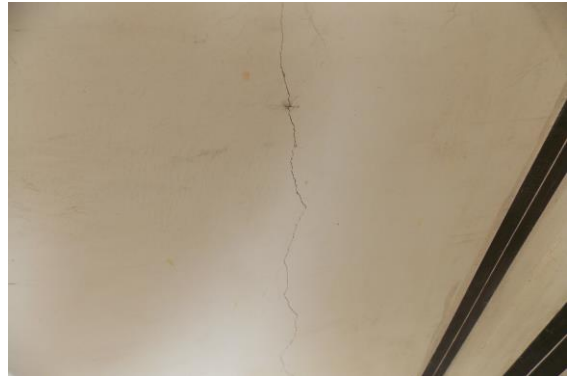
Photo 160
Peeling of Plaster on Roof of Vrandha 2 of Part A2 Upper Ground Floor

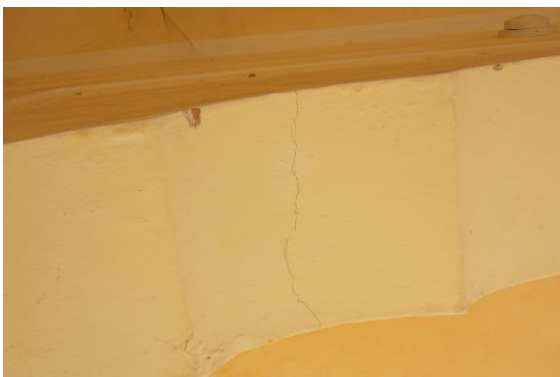
Photo 161
Plaster Crack on Wall No. 2 of Vrandha 2 of Part A2 Upper Ground Floor

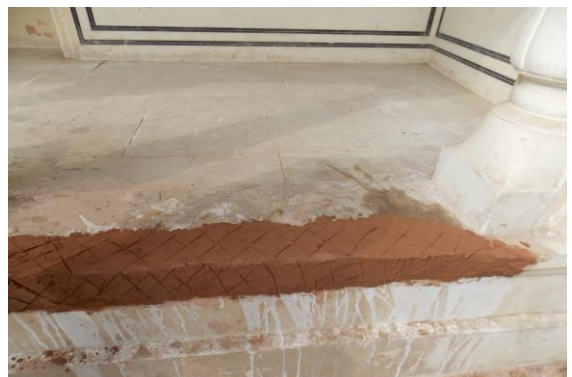
Photo 162
Plaster Crack on Roof of Gate of Part A2 Upper Ground Floor

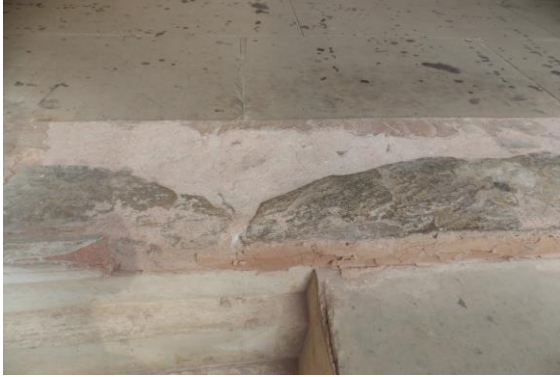
Photo 163
Damaged Portion on Wall No. 3 of Out Side Floor of Part A2 Upper Ground Floor

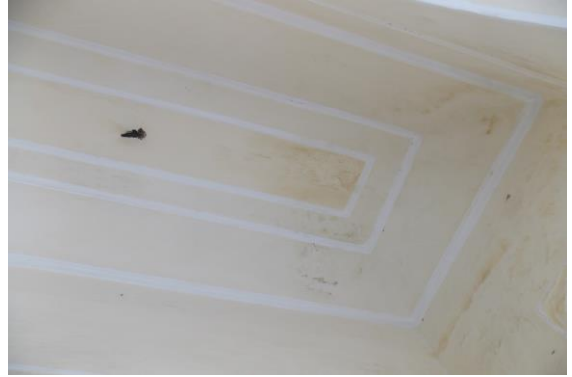
Photo 164
Damaged Portion on Varanda 4 Out Side Floor of Part A2 Upper Ground Floor

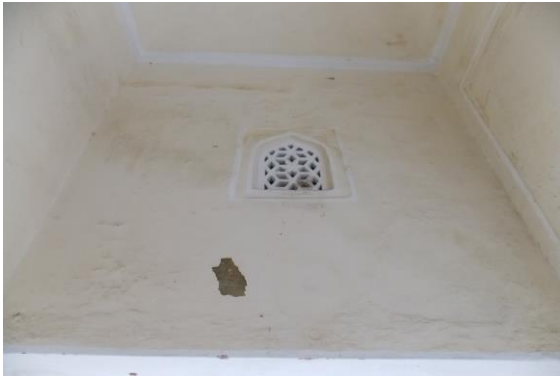
Photo 165
Dampness/Seepage on Roof of Vrandha 4 of Part A2 Upper Ground Floor

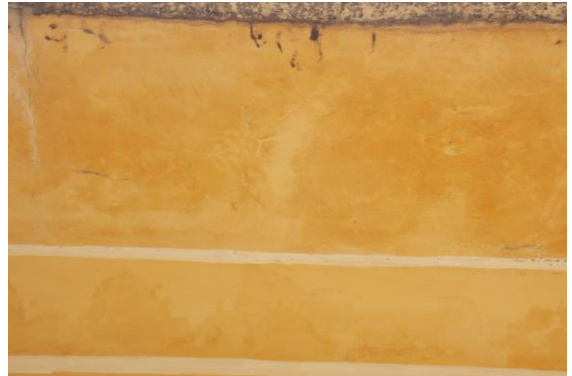
Photo 166
Dampness/Seepage on Wall No. 3 of Vrandha 4 of Part A2 Upper Ground Floor

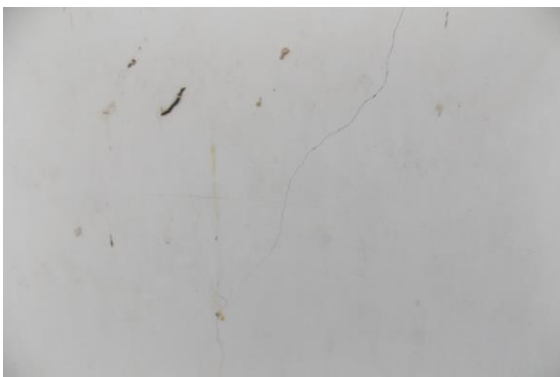
Photo 167
Dampness/Seepage on Wall No. 3 of Sunshade of Part A2 Upper Ground Floor

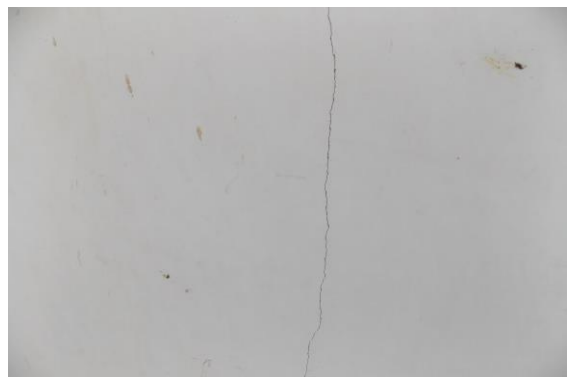
Photo 168
Plaster Crack on Wall No. 4 of Open Area of Part A2 Upper Ground Floor

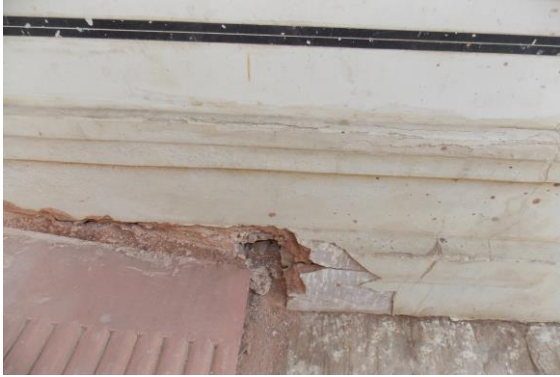
Photo 169
Plaster Crack on Wall No. 4 of Open Area of Part A2 Upper Ground Floor

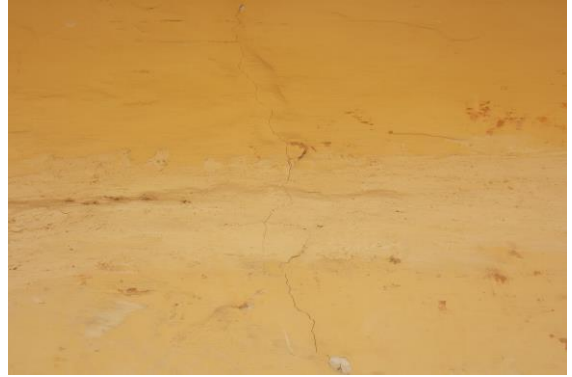
Photo 170

Dampness/Seepage on Wall No. 4 of Open Area of Part A2 Upper Ground Floor

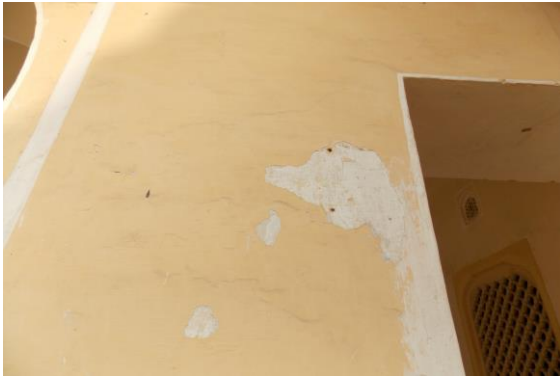
Photo 171

Plaster Crack on Wall No. 4 of Open Area of Part A2 Upper Ground Floor

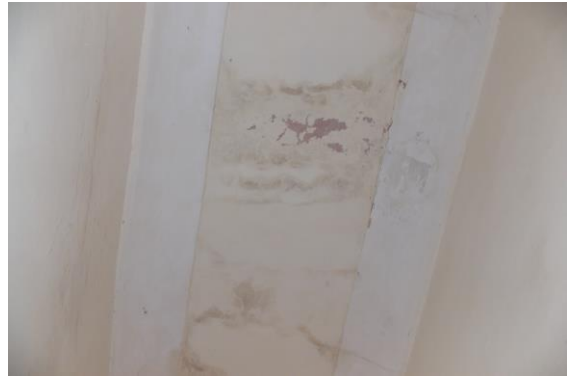
Photo 172

Peeling of Plaster on Wall No. 1 of Open Area of Part A2 Upper Ground Floor

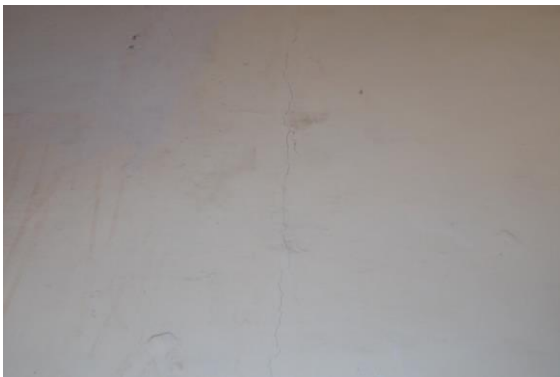
Photo 173

Dampness/Seepage on Roof of Gallery 1 of Part A2 Upper Ground Floor

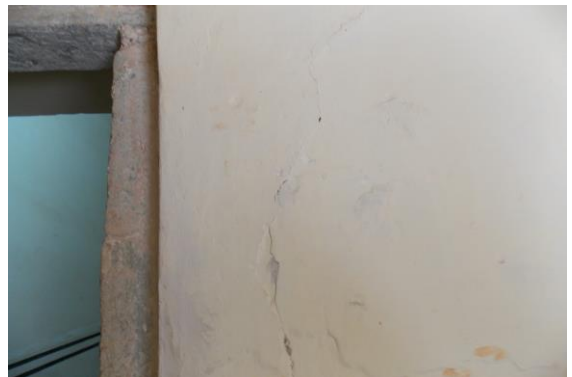
Photo 174

Plaster Crack on Wall No. 1 of Gallery 1 of Part A2 Upper Ground Floor

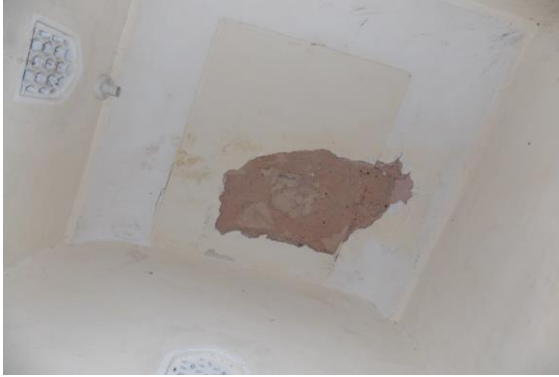
Photo 175

Plaster Crack on Wall No. 4 of Gallery 1 of Part A2 Upper Ground Floor

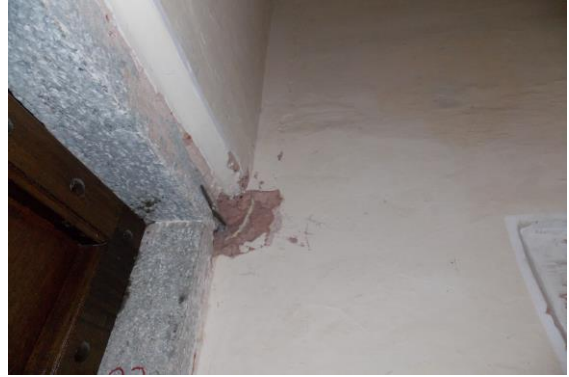
Photo 176

Dampness/Seepage on Roof of Gallery 2 of Part A2 Upper Ground Floor

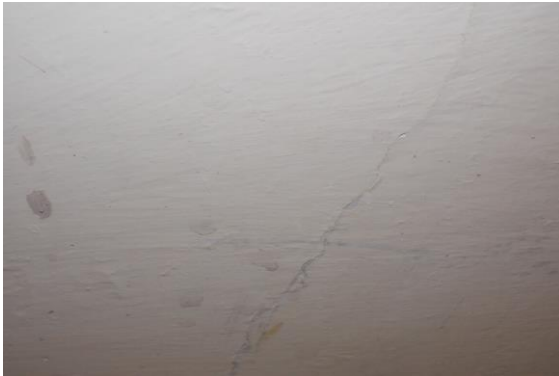
Photo 177

Peeling of Plaster on Wall No. 1 of Gallery 2 of Part A2 Upper Ground Floor

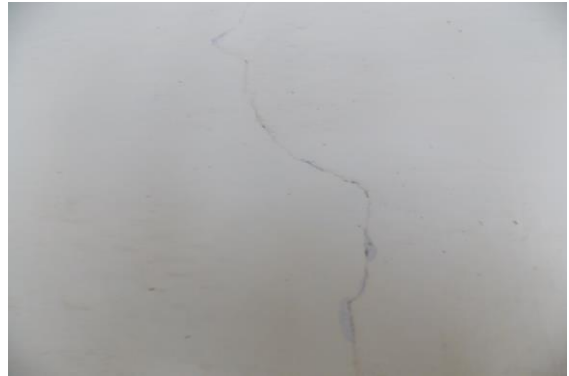
Photo 178

Plaster Crack on Wall No. 3 of Gallery 2 of Part A2 Upper Ground Floor

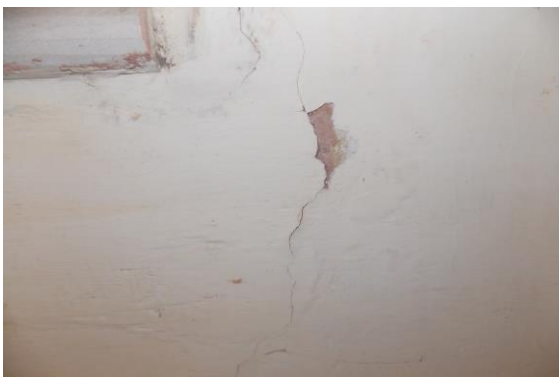
Photo 179

Plaster Crack on Wall No. 4 of Gallery 2 of Part A2 Upper Ground Floor

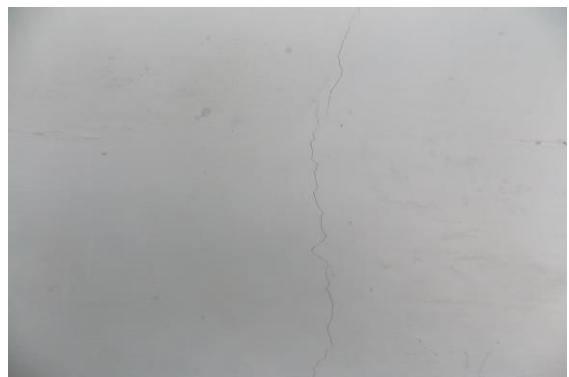
Photo 180

Plaster Crack on Wall No. 3 of Gallery 2 of Part A2 Upper Ground Floor

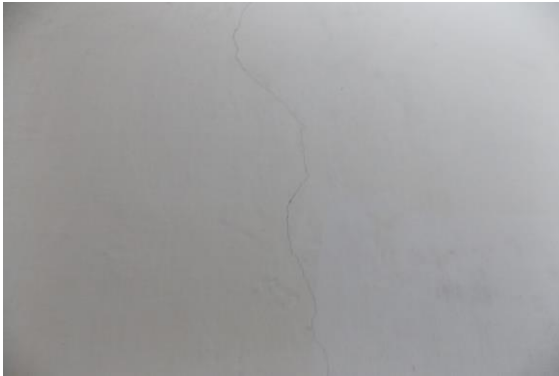
Photo 181

Plaster Crack on Wall No. 4 of Gallery 2 of Part A2 Upper Ground Floor

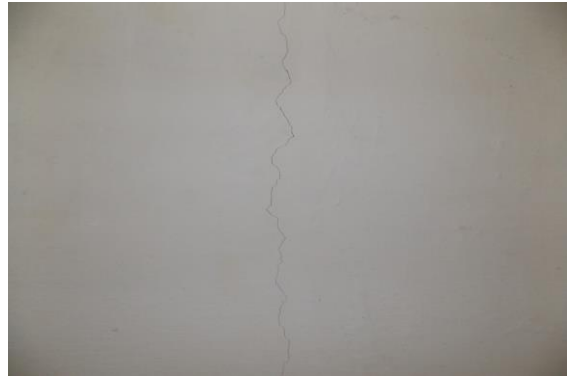
Photo 182

Plaster Crack on Wall No. 2 of Gallery 2 of Part A2 Upper Ground Floor

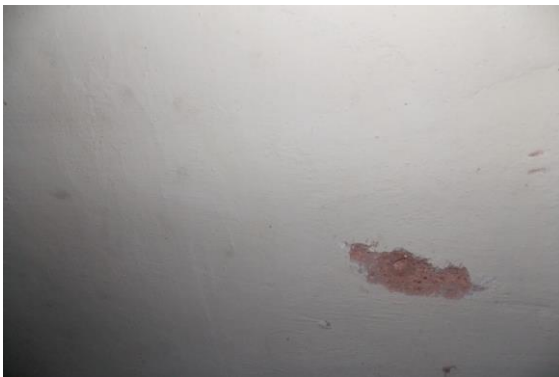
Photo 183

Plaster Crack on Wall No. 6 of Gallery 2 of Part A2 Upper Ground Floor

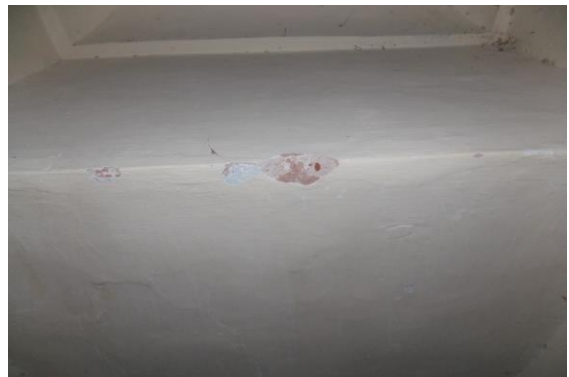
Photo 184

Peeling of Plaster on Wall No. 2 of Gallery 3 of Part A2 Upper Ground Floor

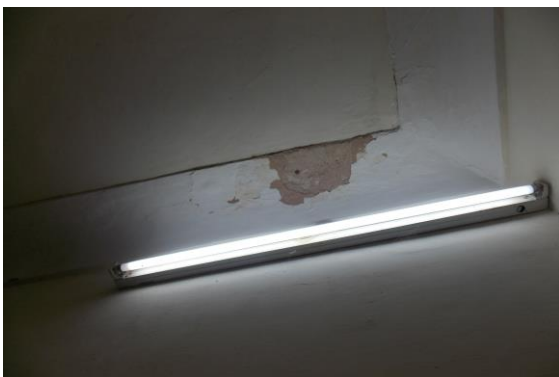
Photo 185

Peeling of Plaster on Roof of Gallery 3 of Part A2 Upper Ground Floor

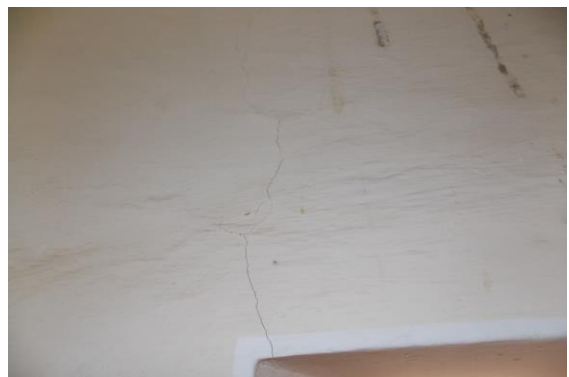
Photo 186

Peeling of Plaster on Roof of Gallery 4 of Part A2 Upper Ground Floor

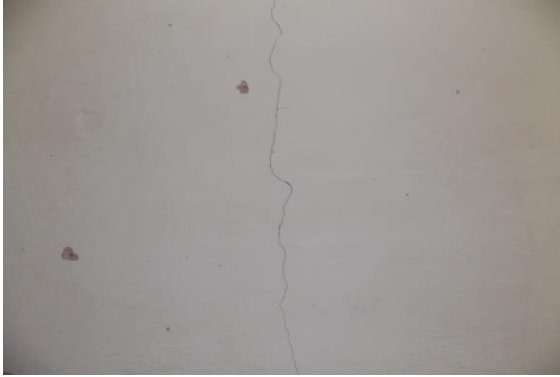
Photo 187

Plaster Crack on Wall No. 1 of Gallery 4 of Part A2 Upper Ground Floor

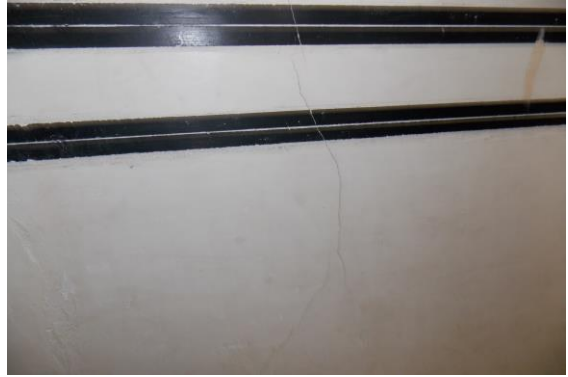
Photo 188

Plaster Crack on Wall No. 1 of Gallery 4 of Part A2 Upper Ground Floor

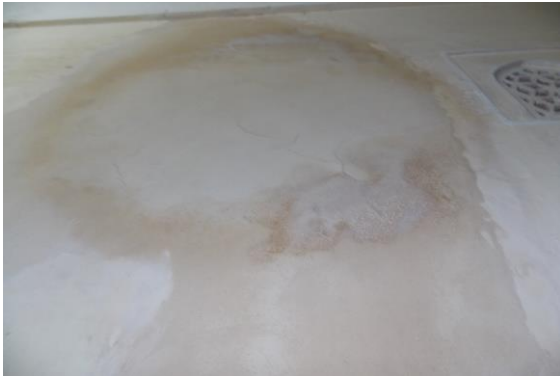
Photo 189

Plaster Crack on Wall No. 2 of Gallery 4 of Part A2 Upper Ground Floor

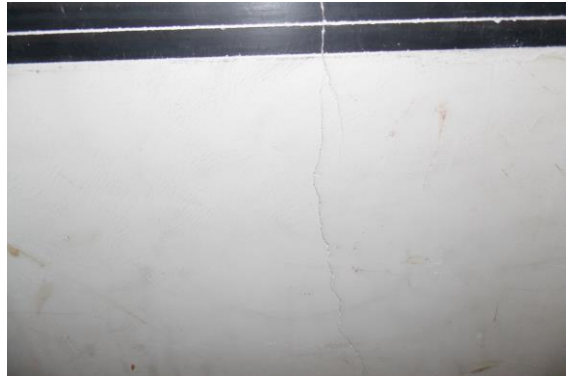
Photo 190

Damaged Portion on Wall No. 1 of Gallery 4 of Part A2 Upper Ground Floor

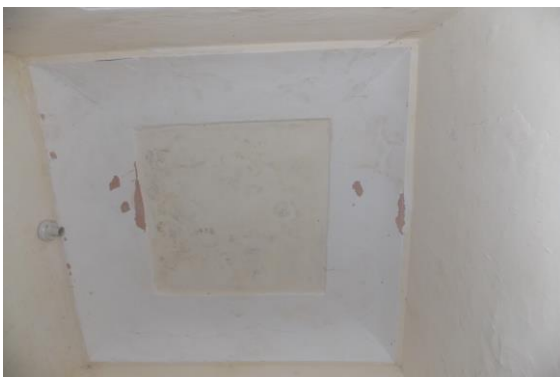
Photo 191

Plaster Crack on Wall No. 2 of Gallery 4 of Part A2 Upper Ground Floor

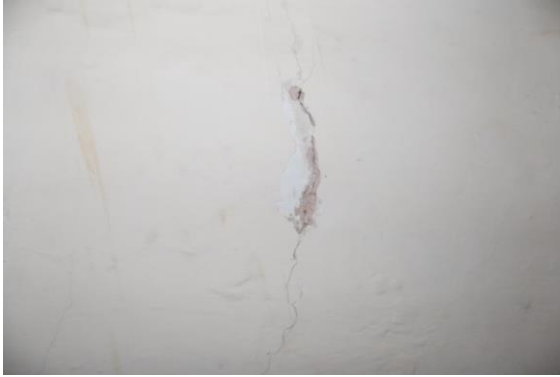
Photo 194

Peeling of Plaster on Wall No. 2 of Gallery 4 of Part A2 Upper Ground Floor

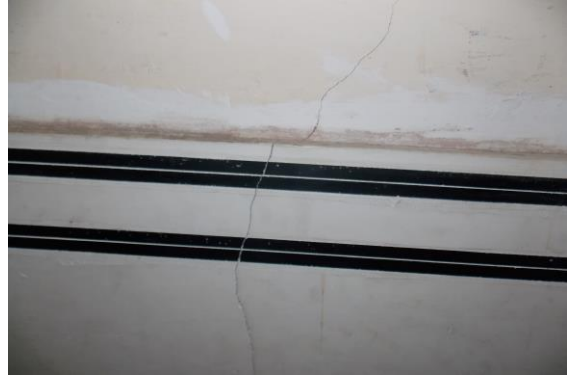
Photo 195

Plaster Crack on Wall No. 2 of Gallery 4 of Part A2 Upper Ground Floor

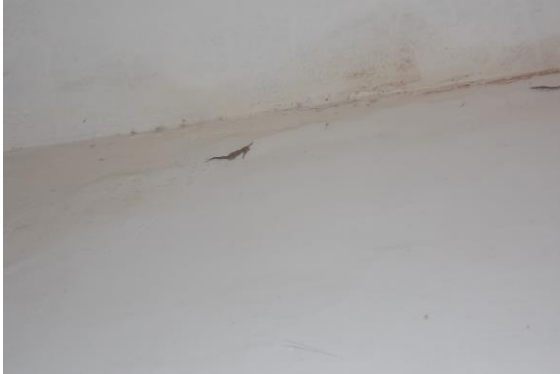
Photo 196

Peeling of Plaster on Wall No. 1 of Gallery 5 of Part A2 Upper Ground Floor

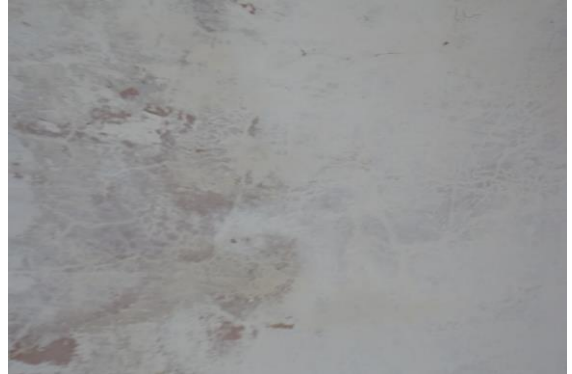
Photo 197

Dampness/Seepage on Roof of Gallery 5 of Part A2 Upper Ground Floor

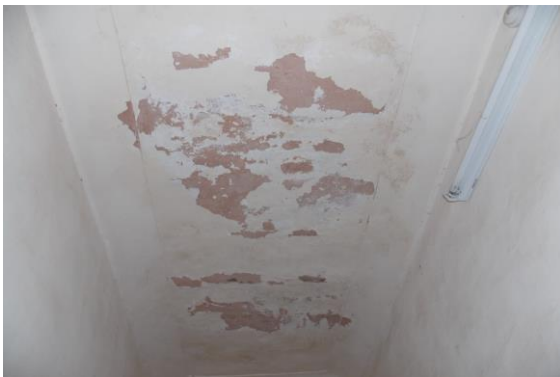
Photo 198

Dampness/Seepage on Roof of Room No. 1 of Part A2 Upper Ground Floor

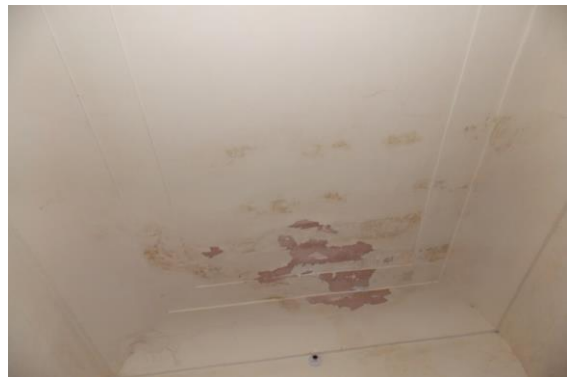
Photo 199

Peeling of Plaster on Roof of Room No. 2 of Part A2 Upper Ground Floor

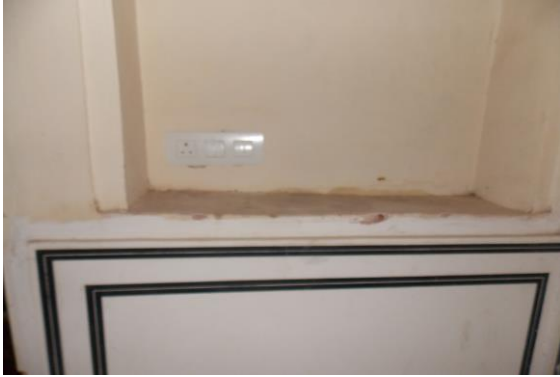
Photo 200
Peeling of Plaster on Wall No. 3 of Open Area 2 of Part A2 Upper Ground Floor

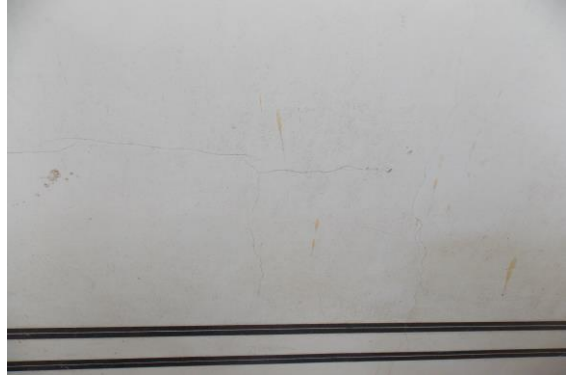
Photo 201
Plaster Crack on Wall No. 3 of Open Area 2 of Part A2 Upper Ground Floor

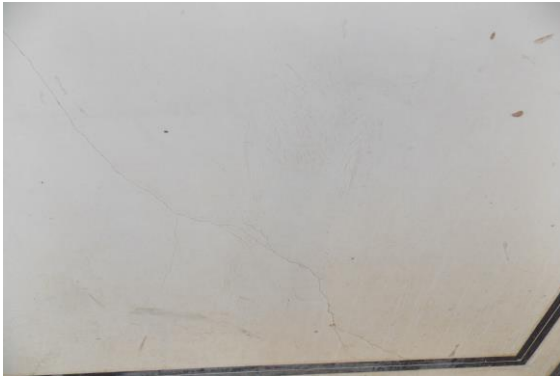
Photo 202
Plaster Crack on Wall No. 4 of Open Area 2 of Part A2 Upper Ground Floor

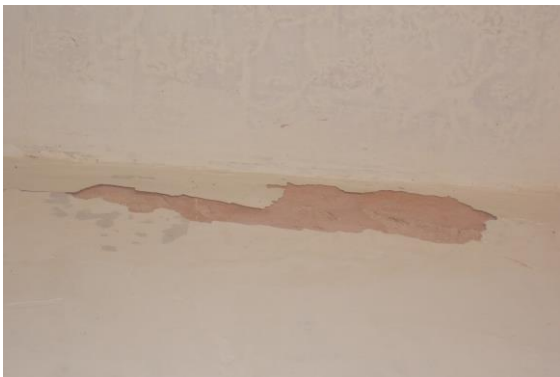
Photo 204
Peeling of Plaster on Wall No. 1 of Gallery 5 of Part A2 Upper Ground Floor

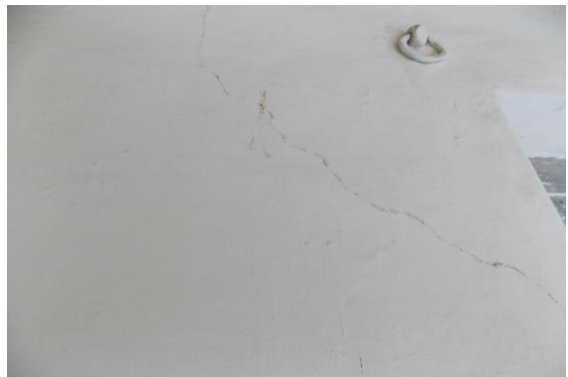
Photo 205
Plaster Crack on Wall No. 1 of Gallery 7 of Part A2 Upper Ground Floor

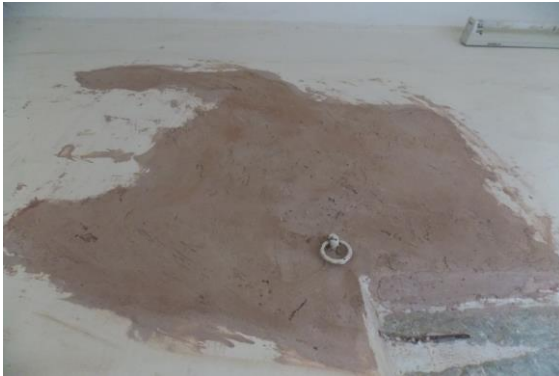
Photo 206

Damaged Portion on Wall No. 1 of Gallery 7 of Part A2 Upper Ground Floor

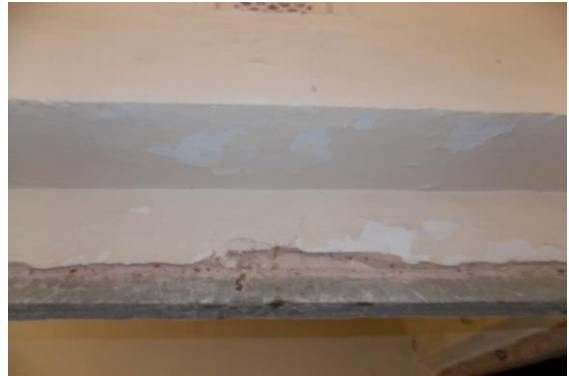
Photo 207

Peeling of Plaster on Wall No. 4 of Gate of Gallery 7 of Part A2 Upper Ground Floor

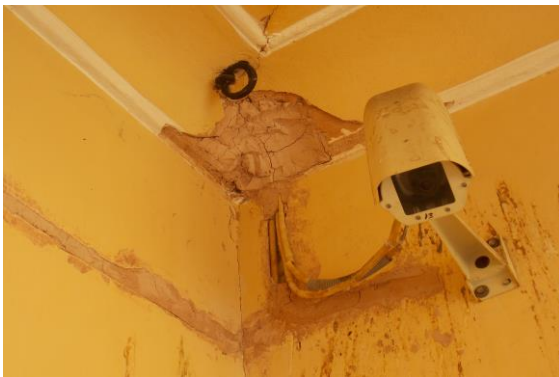
Photo 208

Damaged Portion on Wall No. 1 & 4 of Sunshade of Open Area 4 of Part A2 Upper Ground Floor

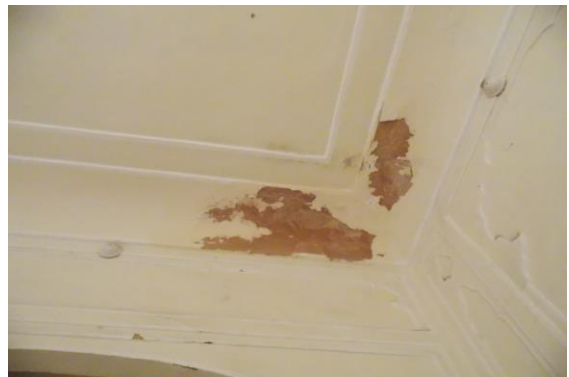
Photo 209

Peeling of Plaster on Roof of Veranda 9 Roof of Part A2 Upper Ground Floor
