Pre Building Condition Survey Report

Name and Address of Structure :	Badi Chopar Station Area
---------------------------------	--------------------------

Name of the Project	Contract JMRC-UG1B “Design and Construction of Tunnel between Chandpole and Badi Chouper and reverse line by Shield TBM, Underground Metro Stations at Choti Chouper and Badi Chouper by Cut and Cover Methods on East West Corridor of Jaipur Metro Rail Corporation Limited .”	
Owner :

Pre - Condition Building Survey for Construction of Underground Stations from Chandpole to Bari Chouper and reversal line

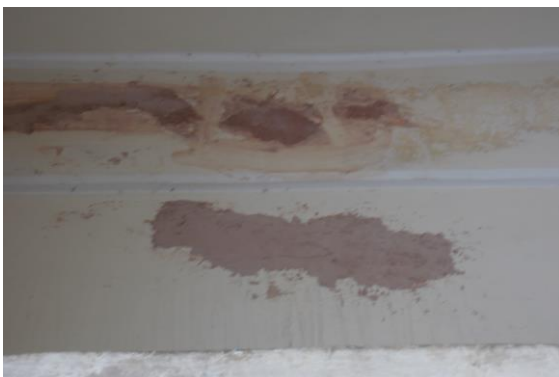
Photo 210

Damaged Portion on Roof of Veranda 8 Roof of Part A2 Upper Ground Floor

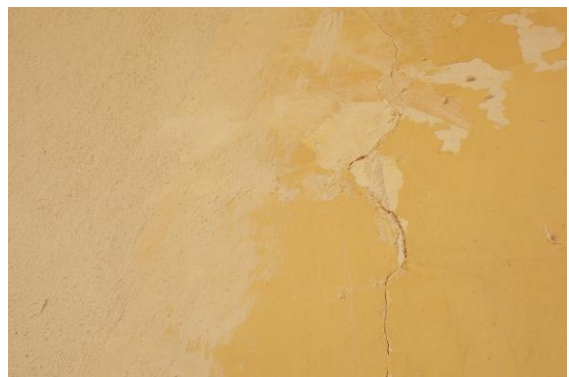
Photo 211

Damaged Portion on Wall No. 3 of Open Area 4 of Part A2 Upper Ground Floor

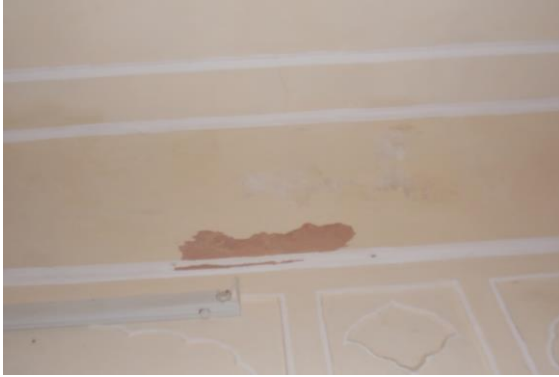
Photo 212

Peeling of Plaster on Roof & Wall No. 3 of Vrandha 7 of Part A2 Upper Ground Floor

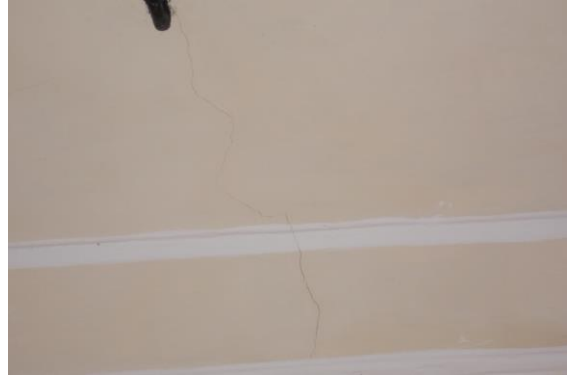
Photo 213

Plaster Crack on Roof of Vrandha 7 of Part A2 Upper Ground Floor

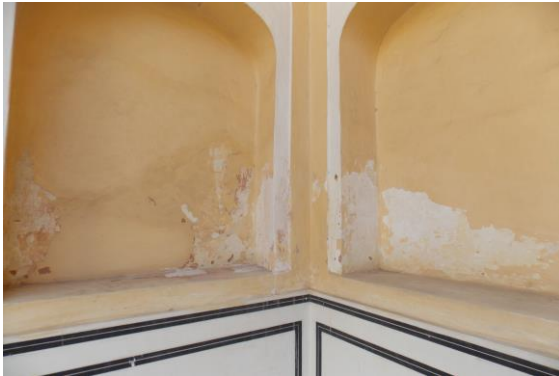
Photo 214

Peeling of Plaster on Wall No. 1 & 3 of Vrandha 7 of Part A2 Upper Ground Floor

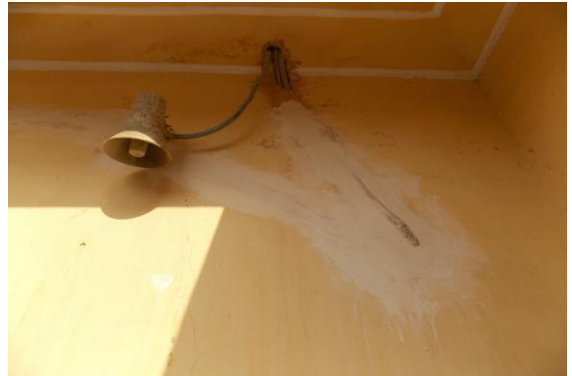
Photo 215

Damaged Portion on Wall No. 2 of Vrandha 7 of Part A2 Upper Ground Floor

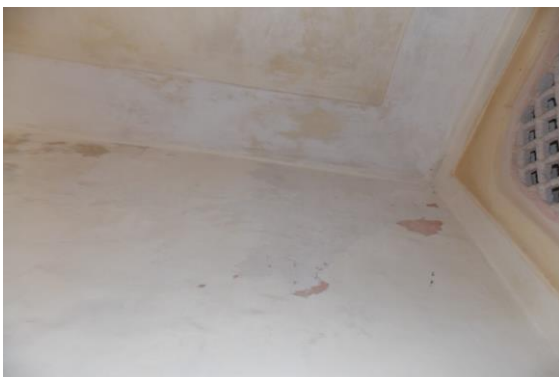
Photo 216

Dampness/Seepage on Wall No. 4 of Gallery 6 of Part A2 Upper Ground Floor

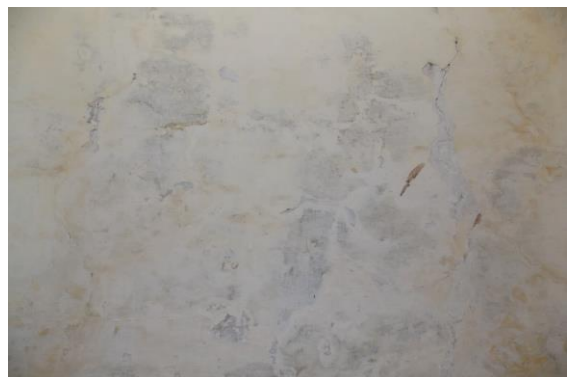
Photo 217

Dampness/Seepage on Wall No. 1 of Gallery 8 of Part A2 Upper Ground Floor

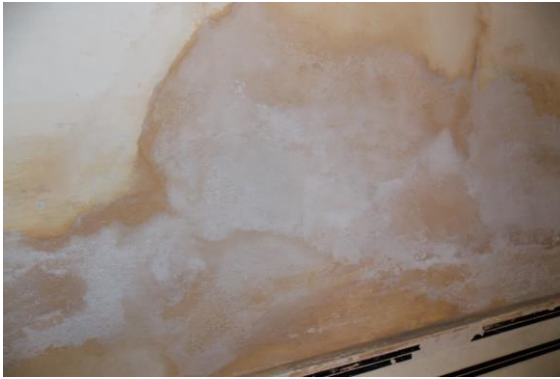
Photo 218
Dampness/Seepage on Wall No. 1 of Gallery 8 of Part A2 Upper Ground Floor

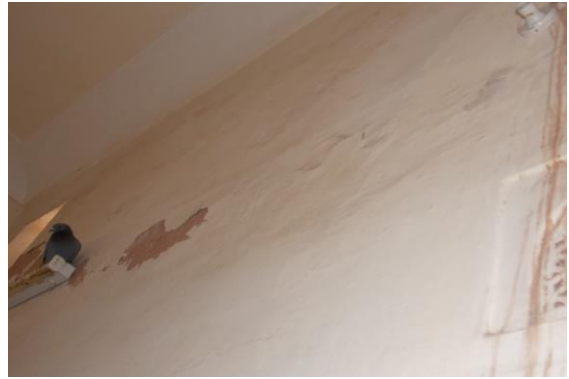
Photo 219
Peeling of Plaster on Wall No. 2 of Gallery 8 of Part A2 Upper Ground Floor

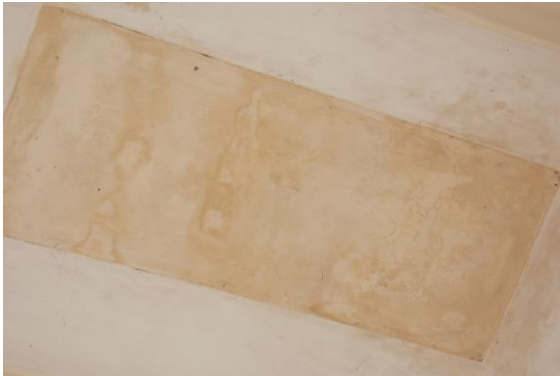
Photo 220
Dampness/Seepage on Roof of Gallery 8 of Part A2 Upper Ground Floor

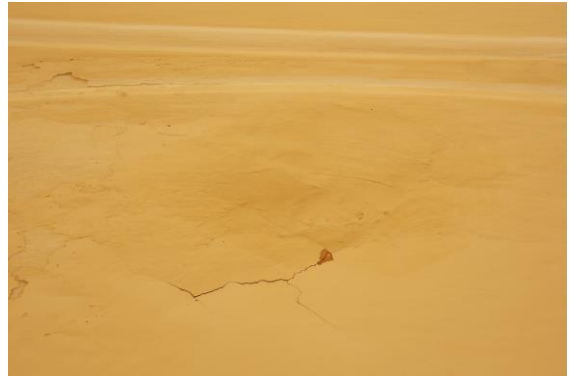
Photo 221
Peeling of Plaster on Wall No. 2 of Vrandra 10 of Part A2 Upper Ground Floor

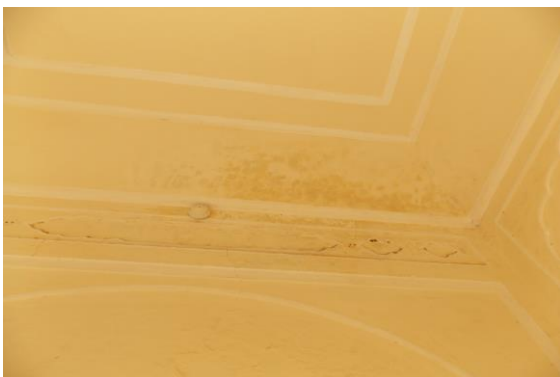
Photo 222
Dampness/Seepage on Wall No. Roof & 1 of Vrandra 10 of Part A2 Upper Ground Floor

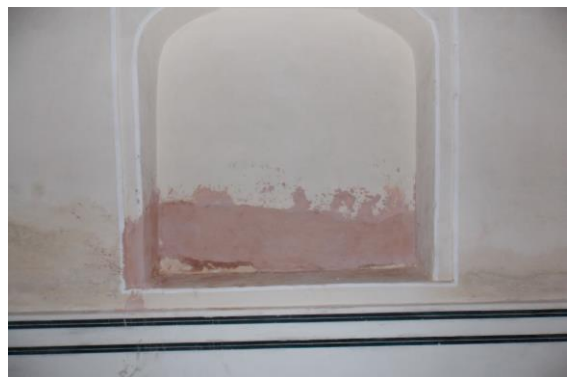
Photo 223
Damaged Portion on Wall No. 4 of Room No. 8 of Part A2 Upper Ground Floor

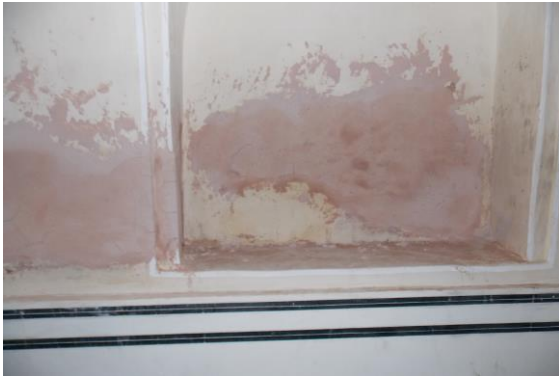
Photo 224

Damaged Portion on Wall No. 1 of Room No. 8 of Part A2 Upper Ground Floor

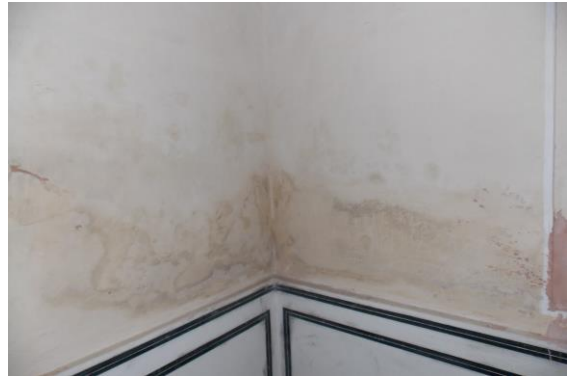
Photo 225

Dampness/Seepage on Wall No. 1 & 4 of Room No. 8 of Part A2 Upper Ground Floor

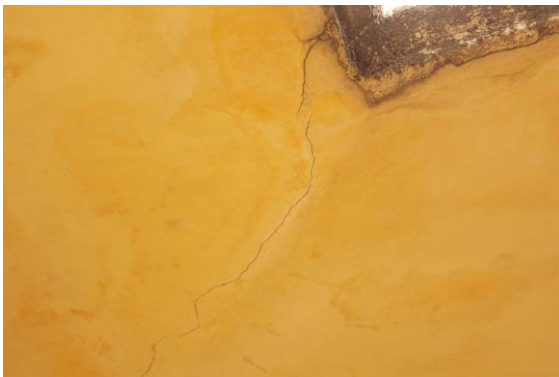
Photo 226

Plaster Crack on Wall No. 1 of Sunshade Open Area of Part B2 Upper Ground Floor

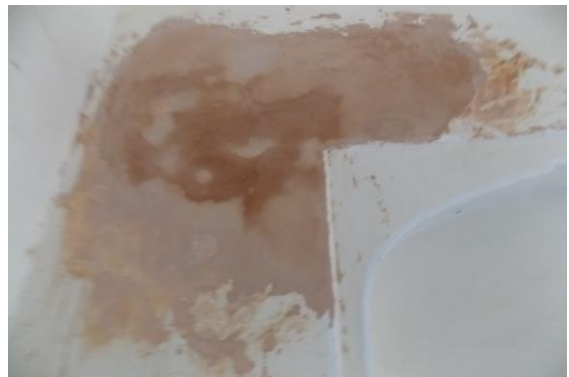
Photo 227

Damaged Portion on Wall No. 1 of Room No. 1 of Part B2 Upper Ground Floor

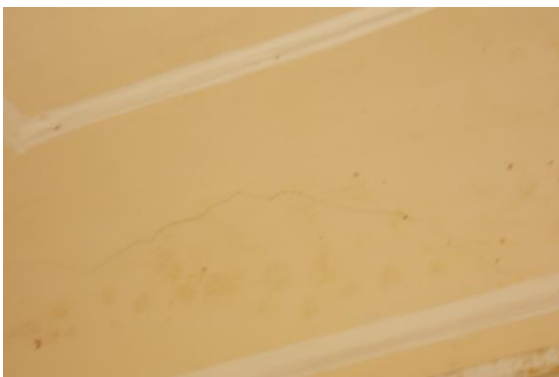
Photo 228

Plaster Crack on Roof of Room No. 5 of Part B2 Upper Ground Floor

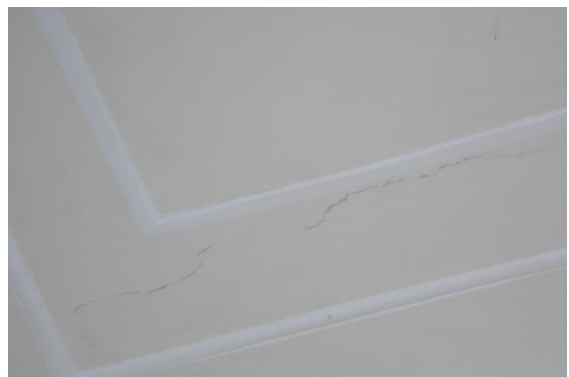
Photo 229

Plaster Crack on Roof of Room No. 5 of Part B2 Upper Ground Floor

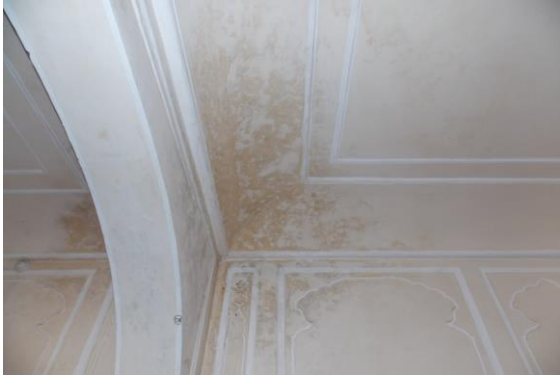
Photo 230

Dampness/Seepage on Wall No. 1 & 4 of Hall No. 1 of Part B2 Upper Ground Floor

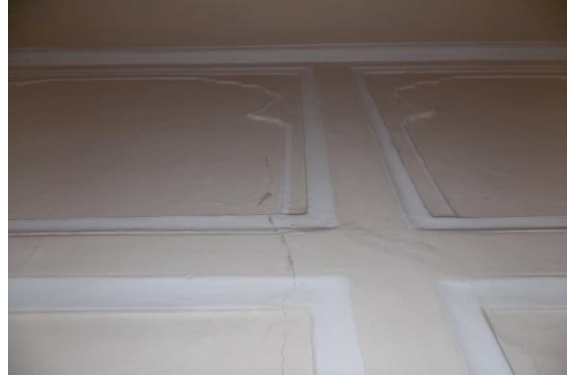
Photo 231

Plaster Crack on Wall No. 2 of Hall No. 1 of Part B2 Upper Ground Floor

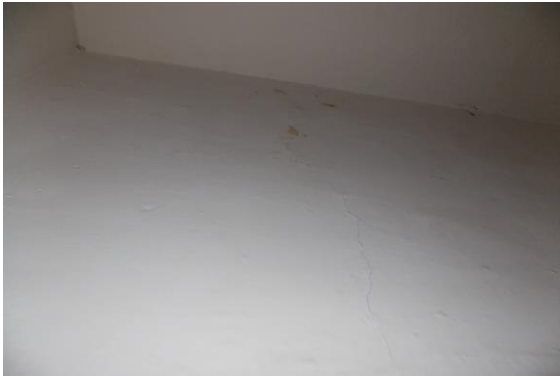
Photo 232

Plaster Crack on Wall No. 4 of Room No. 9 of Part B2 Upper Ground Floor

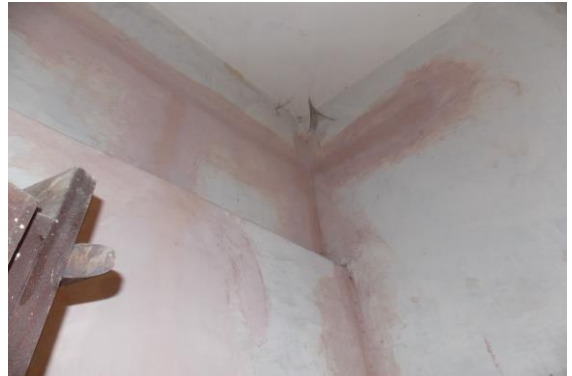
Photo 233

Damaged Portion on Wall No. 1 & 3 of Room No. 7 of Part B2 Upper Ground Floor

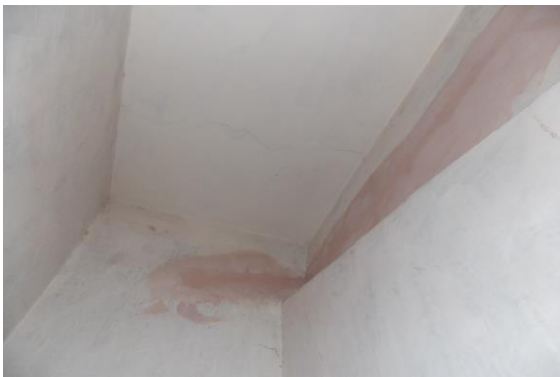
Photo 234

Damaged Portion on Wall No. 2 & 3 of Room No. 7 of Part B2 Upper Ground Floor

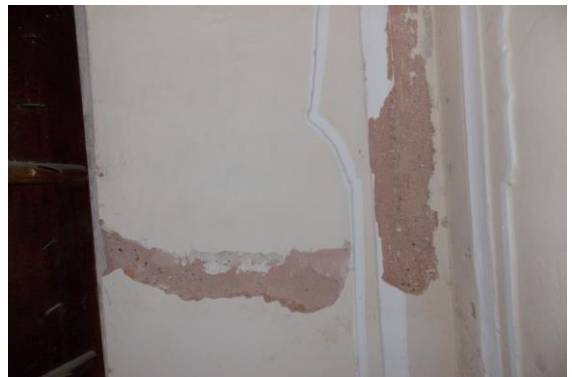
Photo 235

Peeling of Plaster on Wall No. 3 of Room No. 5 of Part B2 Upper Ground Floor

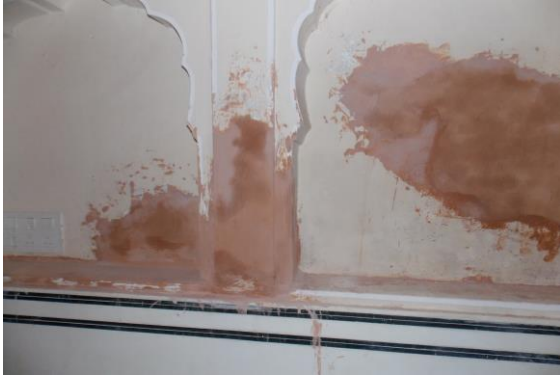
Photo 236

Damaged Portion on Wall No. 3 of Room No. 3 of Part B2 Upper Ground Floor

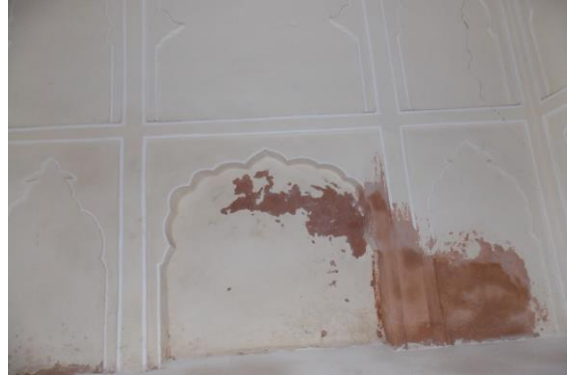
Photo 237

Damaged Portion on Wall No. 1 of Room No. 3 of Part B2 Upper Ground Floor

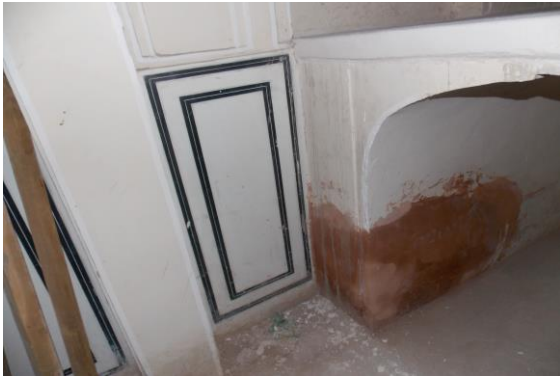
Photo 238

Damaged Portion on Wall No. 4 of Room No. 3 of Part B2 Upper Ground Floor

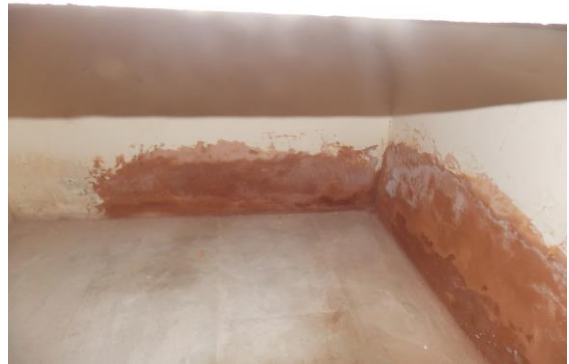
Photo 239

Damaged Portion on Wall No. 2 & 3 of Room No. 3 of Part B2 Upper Ground Floor

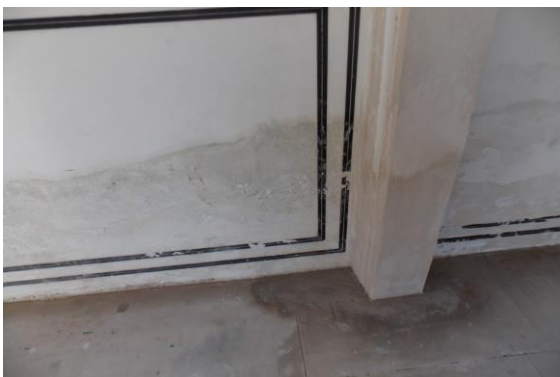
Photo 240

Peeling of Plaster on Wall No. 4 of Vrandra 2 of Part B2 Upper Ground Floor

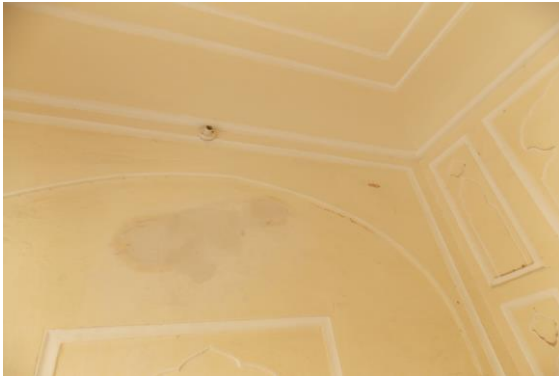
Photo 242

Plaster Crack on Wall No. 1 of Vrandra 2 of Part B2 Upper Ground Floor

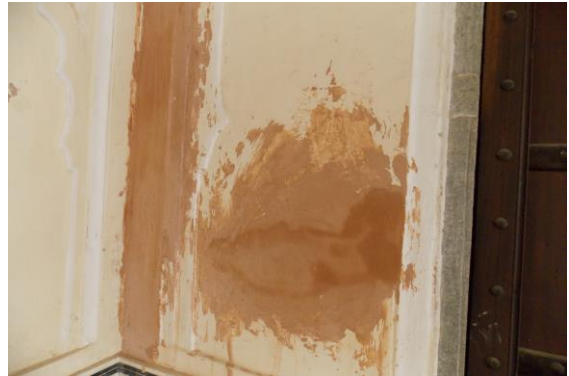
Photo 243

Damaged Portion on Wall No. 2 of Vrandra 3 of Part B2 Upper Ground Floor

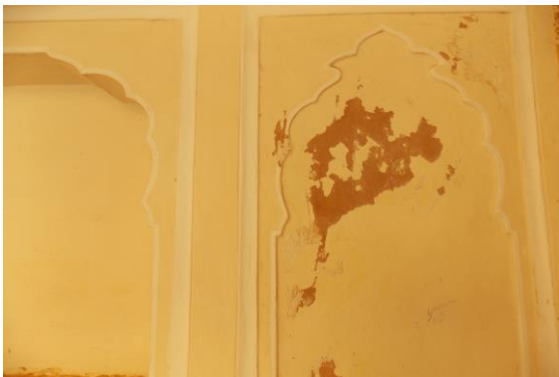
Photo 244

Peeling of Plaster on Wall No. 4 of Vrandra 3 of Part B2 Upper Ground Floor

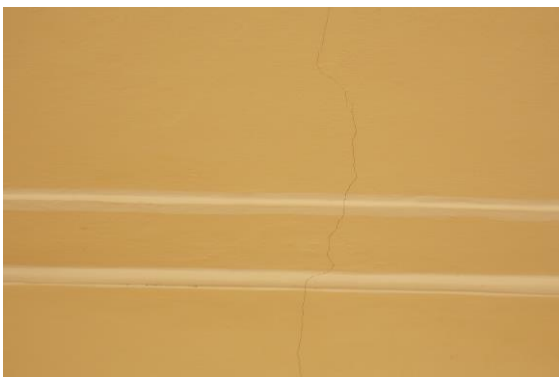
Photo 246

Plaster Crack on Roof of Vrandra 4 of Part B2 Upper Ground Floor

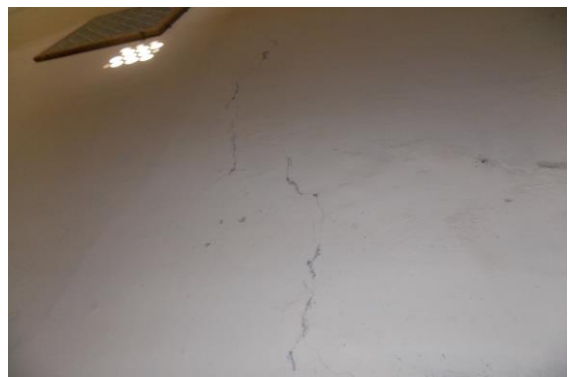
Photo 247

Plaster Crack on Wall No. 1 of Gallery 8 of Part B2 Upper Ground Floor

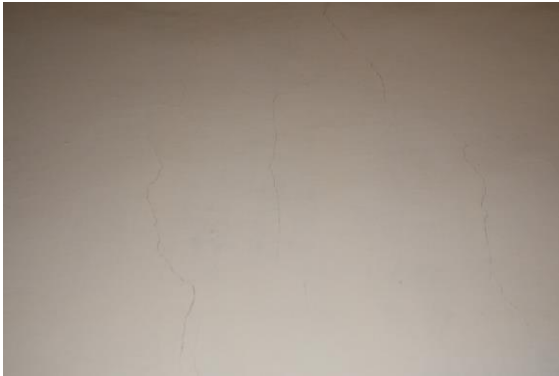
Photo 248
Dampness/Seepage on Wall No. 2 of Gallery 8 of Part B2 Upper Ground Floor

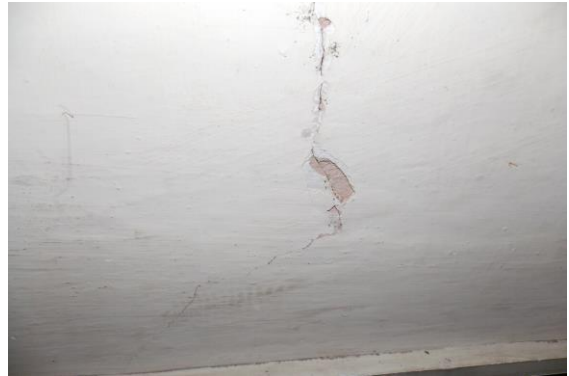
Photo 249
Plaster Crack on Wall No. 2 of Gallery 8 of Part B2 Upper Ground Floor

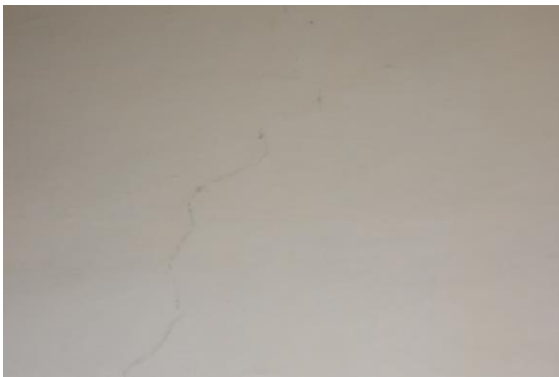
Photo 250
Plaster Crack on Wall No. 1 of Gallery 8 of Part B2 Upper Ground Floor

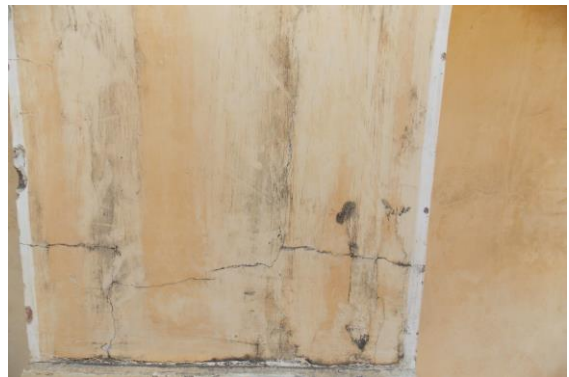
Photo 251
Plaster Crack on Wall No. 4 of Open Area 2 of Terrace of (A2+B2) Open Area

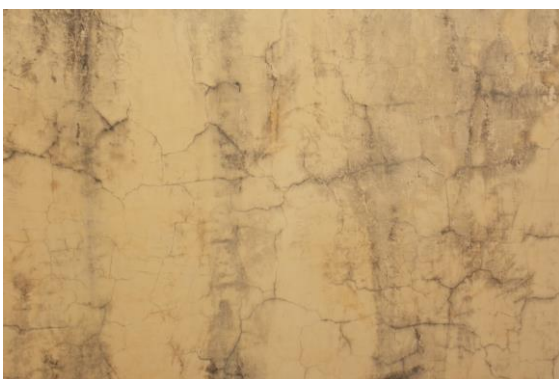
Photo 252
Dampness/Seepage on Wall No. 1 of Open Area 2 of Terrace of (A2+B2) Open Area

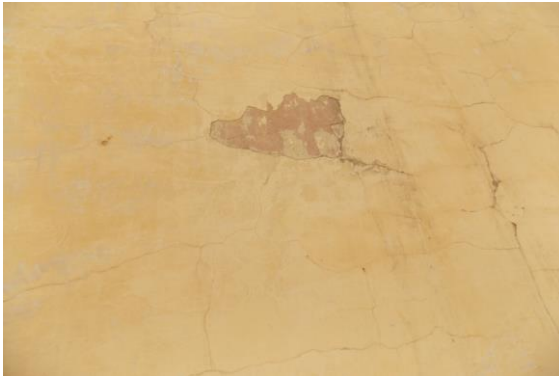
Photo 254

Peeling of Plaster on Wall No. 2 of Open Area 2 of Terrace of (A2+B2) Open Area

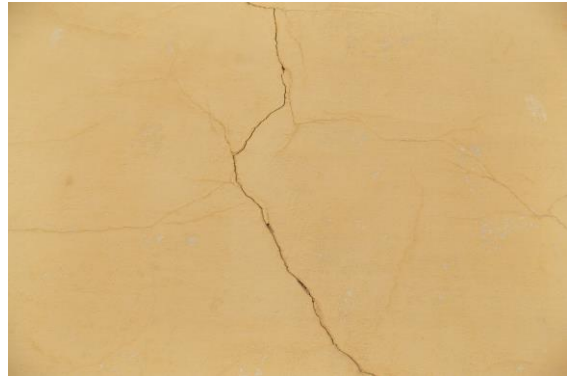
Photo 255

Plaster Crack on Wall No. 2 of Open Area 2 of Terrace of (A2+B2) Open Area

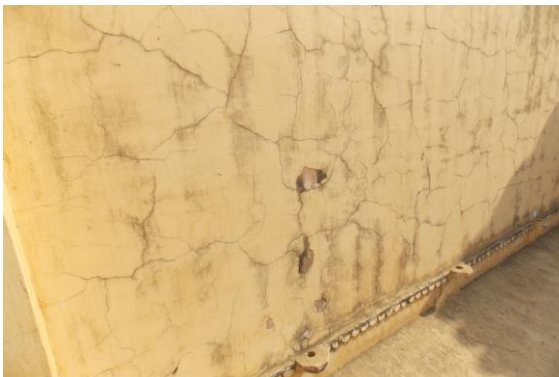
Photo 256

Peeling of Plaster on Wall No. 3 of Open Area 2 of Terrace of (A2+B2) Open Area

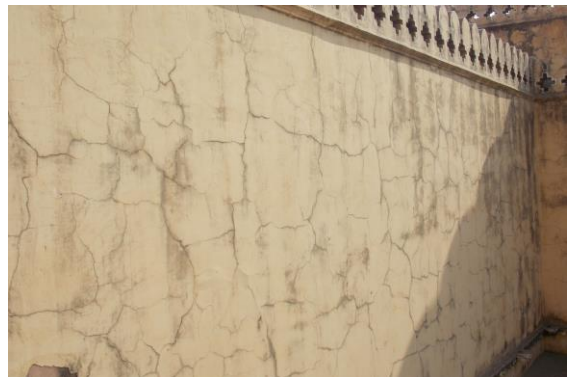
Photo 257

Plaster Crack on Wall No. 3 of Open Area 2 of Terrace of (A2+B2) Open Area

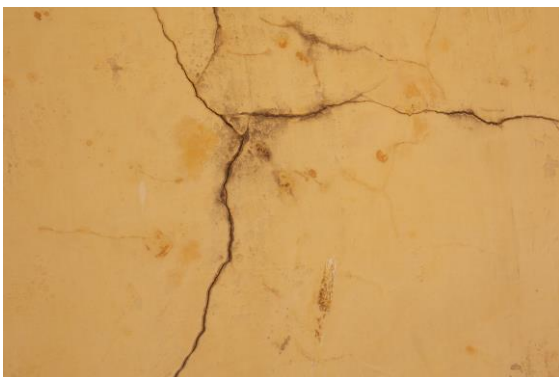
Photo 258

Plaster Crack on Wall No. 4 of Open Area 1 of Terrace of (A2+B2) Open Area

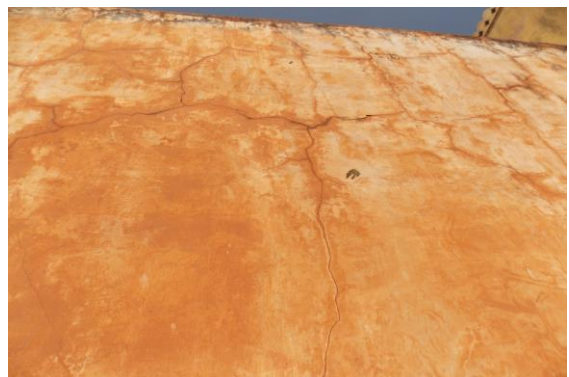
Photo 259

Plaster Crack on Wall No. 2 of Open Area 1 of Terrace of (A2+B2) Open Area

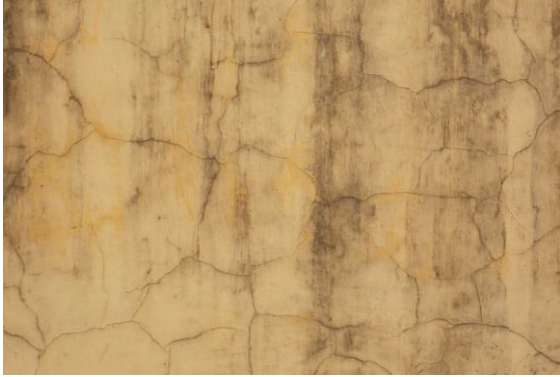
Photo 260

Plaster Crack on Wall No. 3 of Open Area 1 of Terrace of (A2+B2) Open Area

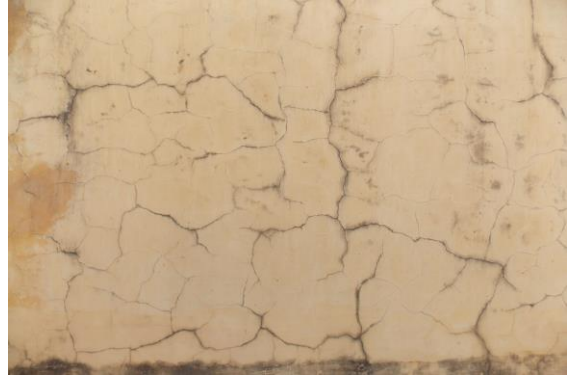
Photo 261

Plaster Crack on Wall No. 6 of Open Area 1 of Terrace of (A2+B2) Open Area

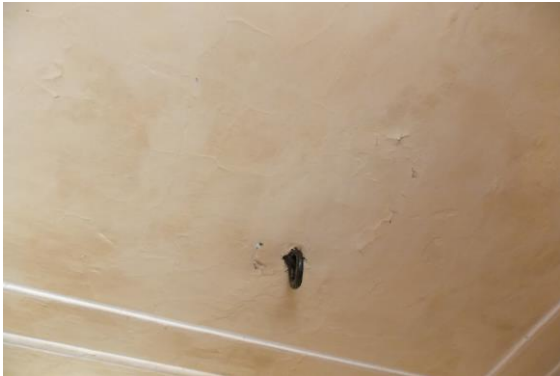
Photo 262

Peeling of Plaster on Roof of Room No. 1 of Terrace of (A2+B2) Open Area

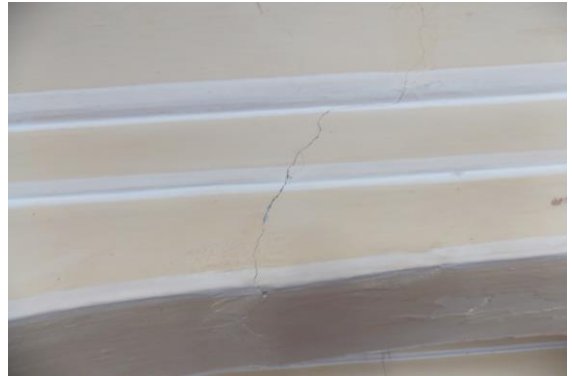
Photo 263

Plaster Crack on Wall No. 4 of Room No. 1 of Terrace of (A2+B2) Open Area

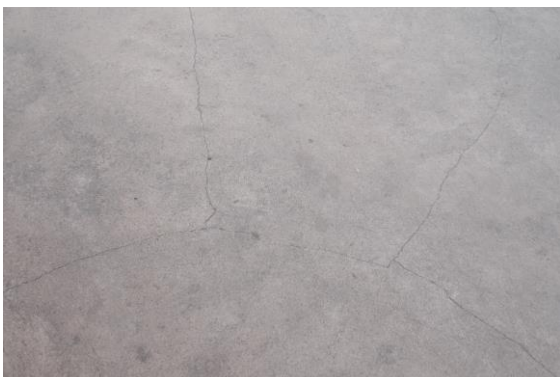
Photo 264

Plaster Crack on Floor of Open Area 1 of Terrace of (A2+B2) Open Area

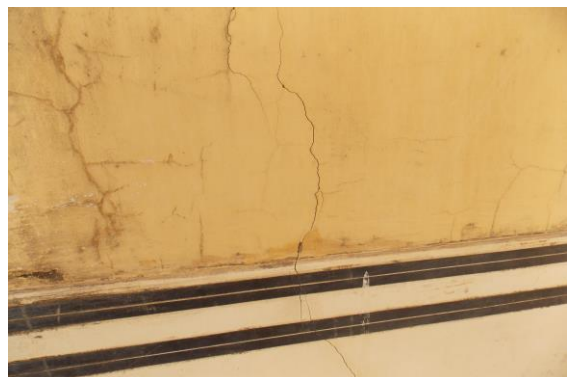
Photo 265

Plaster Crack on Wall No. 1 of Open Area 1 of Terrace of (A2+B2) Open Area

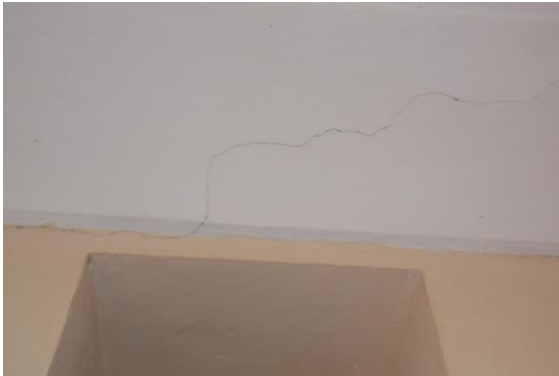
Photo 266

Plaster Crack on Roof of Room No. 2 of Terrace of (A2+B2) Open Area

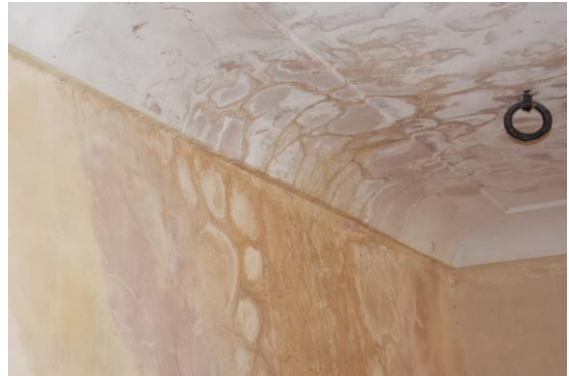
Photo 267

Dampness/Seepage on Roof & Wall No. 4 of Toilet of Terrace of (A2+B2) Open Area

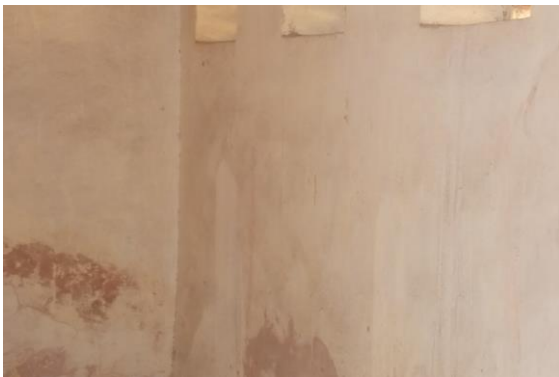
Photo 268

Dampness/Seepage on Wall No. 2 & 3 of Toilet of Terrace of (A2+B2) Open Area

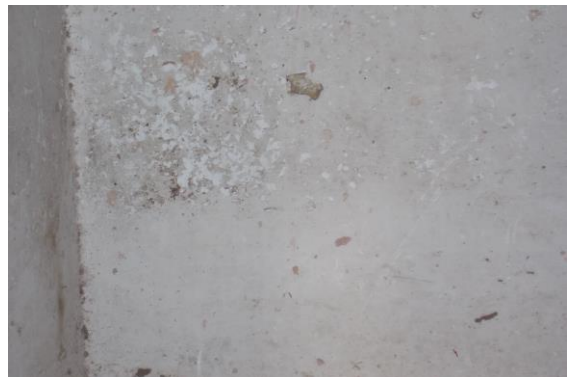
Photo 269

Peeling of Plaster on Wall No. 4 of Room No. 3 of Terrace of (A2+B2) Open Area

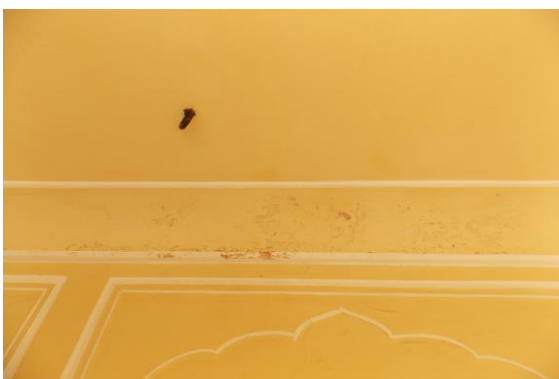
Photo 270

Peeling of Plaster on Roof & 4 of Vrandra of Terrace of (A2+B2) Open Area

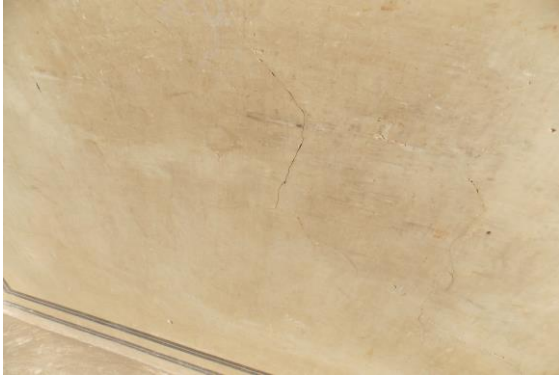
Photo 272

Plaster Crack on Wall No. 2 of Vrandra of Terrace of (A2+B2) Open Area

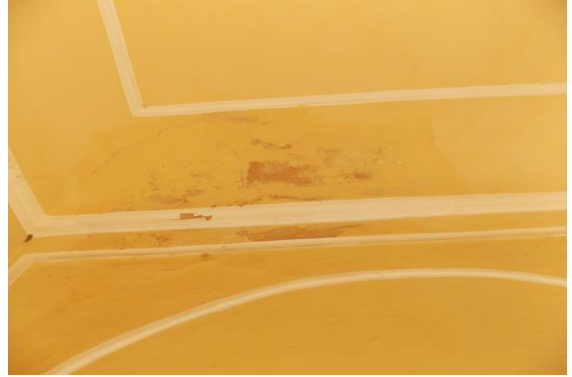
Photo 273

Peeling of Plaster on Wall No. 2 & Roof of Vrandra of Terrace of (A2+B2) Open Area

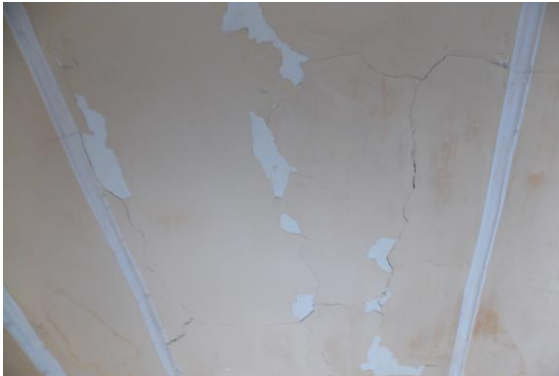
Photo 274

Peeling of Plaster on Roof of Gallery 2 of Terrace of (A2+B2) Open Area

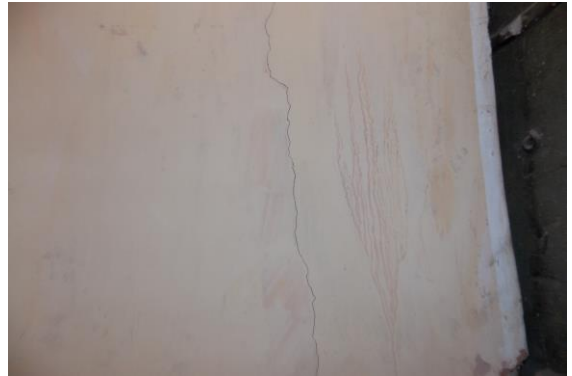
Photo 275

Plaster Crack on Wall No. 3 of Gallery 2 of Terrace of (A2+B2) Open Area

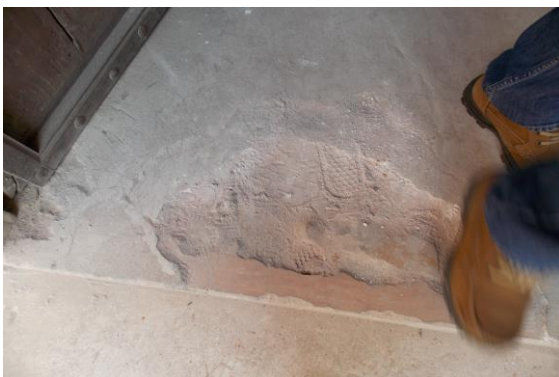
Photo 276

Peeling of Plaster on Floor of Gallery 2 of Terrace of (A2+B2) Open Area

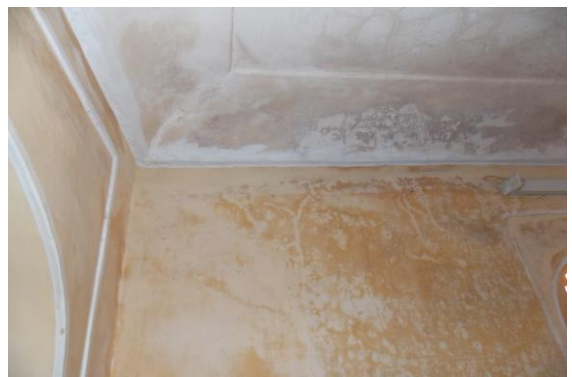
Photo 277

Dampness/Seepage on Wall No. 4 & Roof of Open Gallery 1 of Terrace of (A2+B2) Open Area

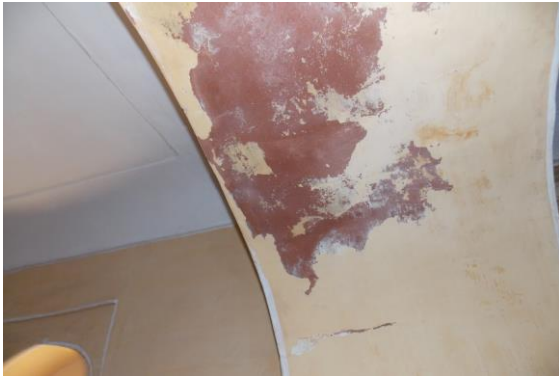
Photo 278
Peeling of Plaster on Roof of Open Gallery 1 of Terrace of (A2+B2) Open Area

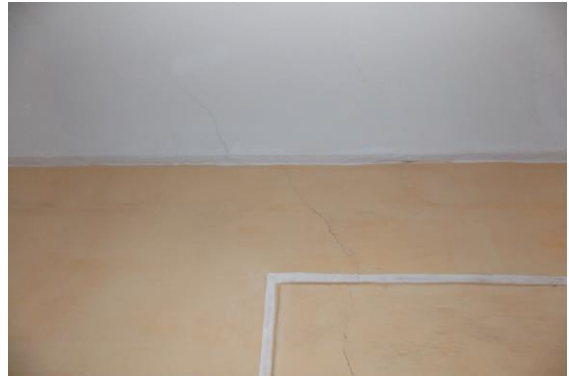
Photo 279
Plaster Crack on Wall No. 4 & Roof of Open Gallery 1 of Terrace of (A2+B2) Open Area

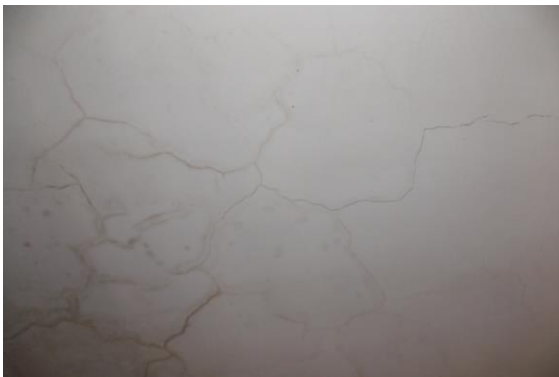
Photo 280
Dampness/Seepage on Roof of Open Gallery 1 of Terrace of (A2+B2) Open Area

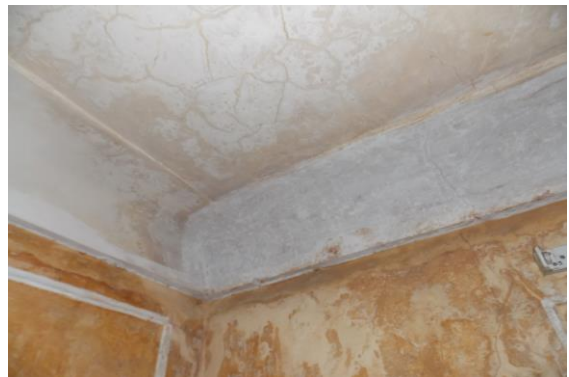
Photo 281
Dampness/Seepage on Wall No. 1, 4 & Roof of Open Gallery 1 of Terrace of (A2+B2) Open Area

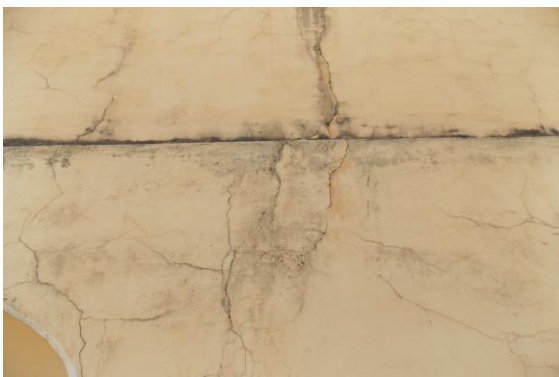
Photo 282
Plaster Crack on Wall No. 2 of Open Area 5 of Terrace of (A2+B2) Open Area

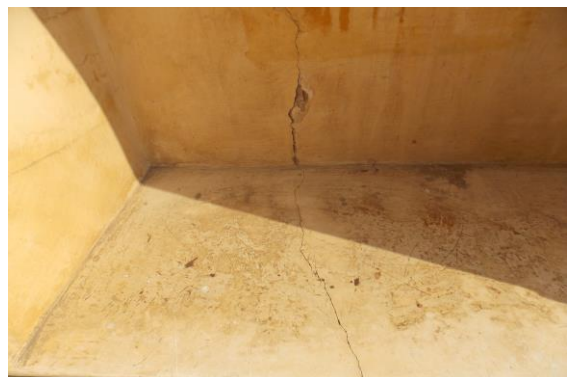
Photo 283
Peeling of Plaster on Wall No. 1 of Open Area 5 of Terrace of (A2+B2) Open Area

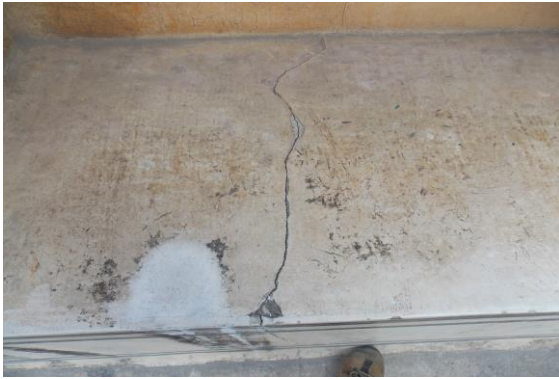
Photo 284
Plaster Crack on Wall No. 1 of Terrace of (A2+B2) Open Area

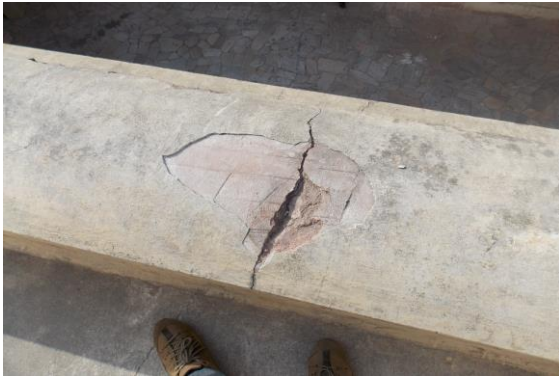
Photo 286
Peeling of Plaster on Parapet wall of Open Area 6 of Terrace of (A2+B2) Open Area

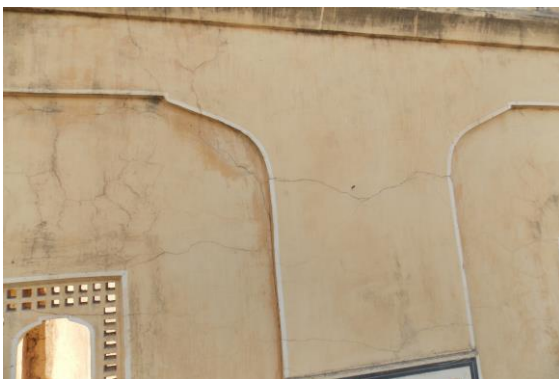
Photo 288
Plaster Crack on Wall No. 4 of Open Area 6 of Terrace of (A2+B2) Open Area

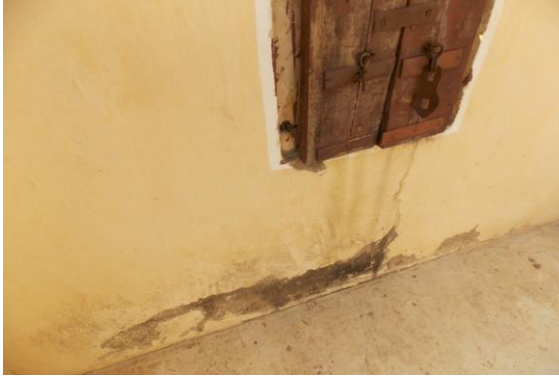
Photo 290

Plaster Crack on Wall No. 2 of Open Area 6 of Terrace of (A2+B2) Open Area

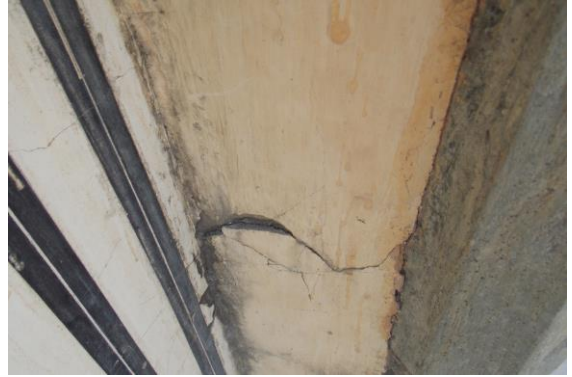
Photo 291

Peeling of Plaster on Outer wall of Tomb 3 of Terrace of (A2+B2) Open Area

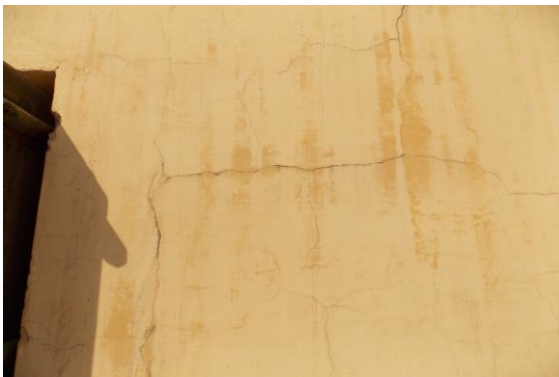
Photo 294

Plaster Crack on Wall No. 3 of Tomb 3 of Terrace of (A2+B2) Open Area

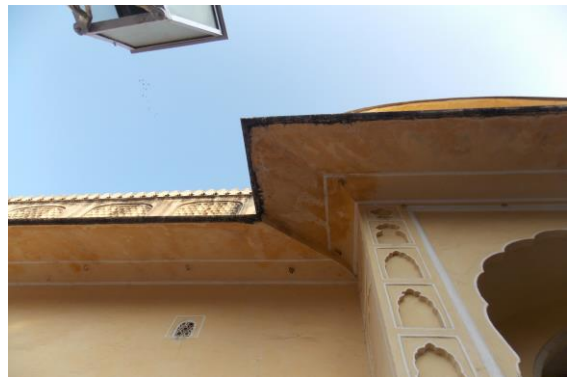
Photo 295

Dampness/Seepage on Sunshade of Ground Floor

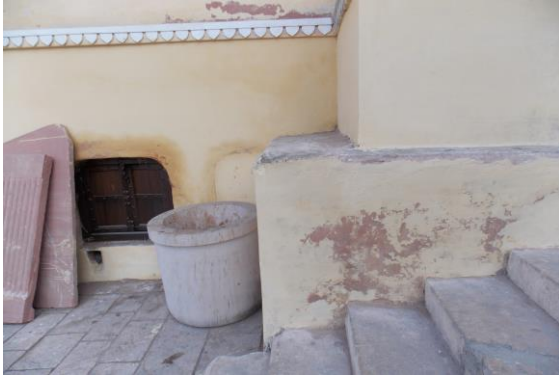
Photo 296
Peeling of Plaster on Outer wall of Ground Floor

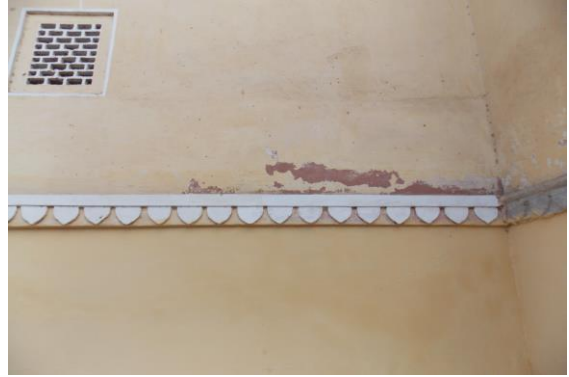
Photo 297
Peeling of Plaster on Wall No. 3 of Outer wall of Ground Floor

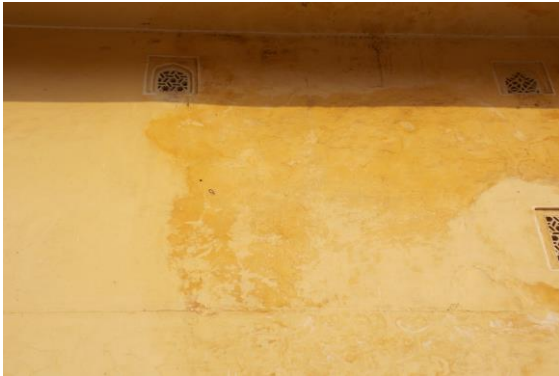
Photo 298
Dampness/Seepage on Wall No. 3 of Outer wall of Upper Ground Floor

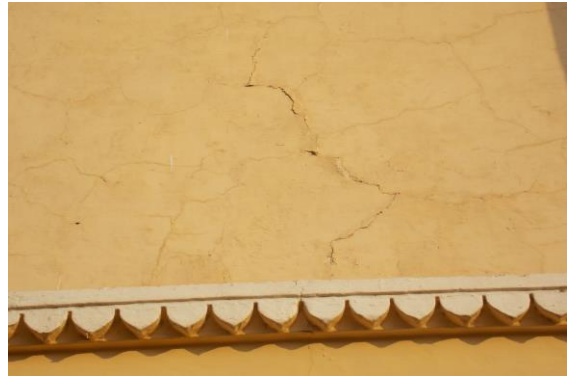
Photo 299
Plaster Crack on Wall No. 3 of Outer wall of Upper Ground Floor

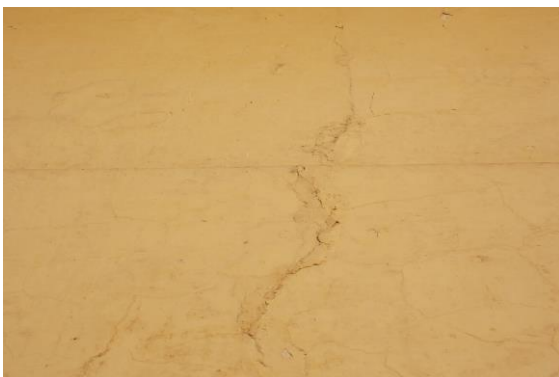
Photo 300
Plaster Crack on Wall No. 3 of Outer wall of Upper Ground Floor

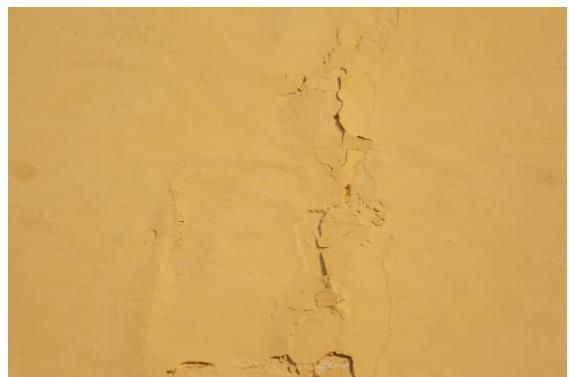
Photo 301
Plaster Crack on Wall No. 3 of Upper Ground Floor

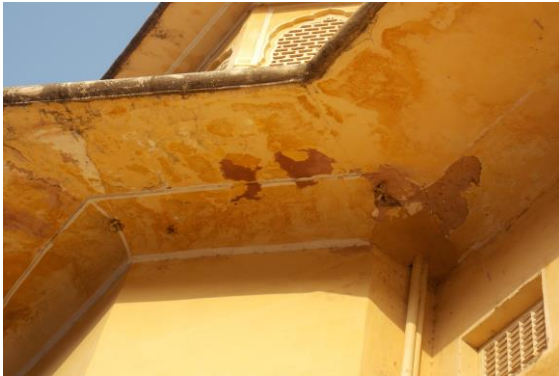
Photo 302

Peeling of Plaster on Sunshade of Main Gate Left Side of Upper Ground Floor

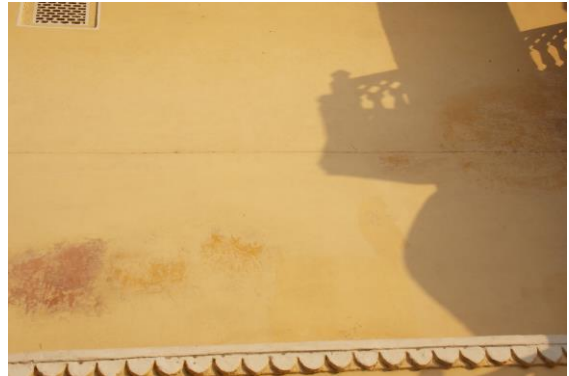
Photo 303

Dampness/Seepage

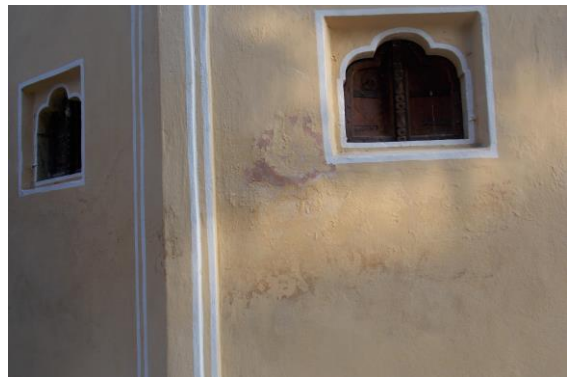
Photo 305

Peeling of Plaster on Wall No. 3 of Outer Wall of Lower G/F of Lower Ground Floor

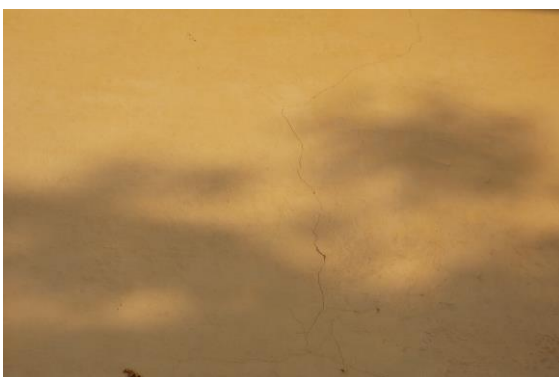
Photo 306

Plaster Crack on Sunshade of Upper Ground Floor

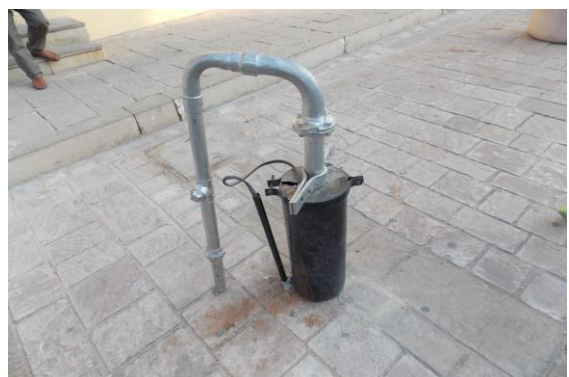
Photo 307

Damaged Portion on Bore Well View

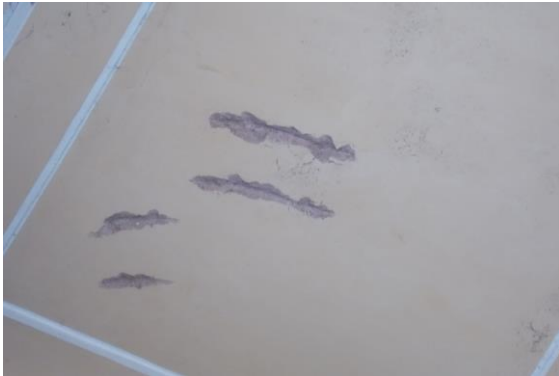
Photo 308

Peeling of Plaster on Roof of Plaster Removal on roof Main Gate from Main Road side of

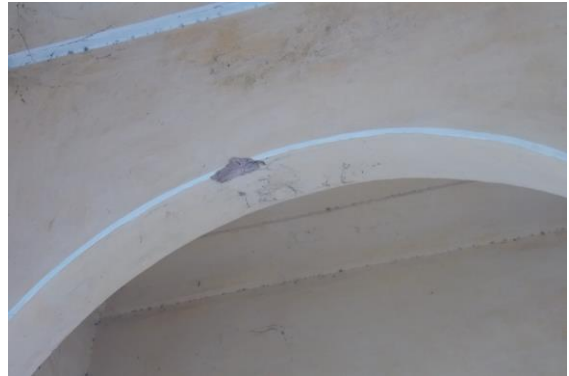
Photo 309

Peeling of Plaster on Wall No. 4 of Space 4 of

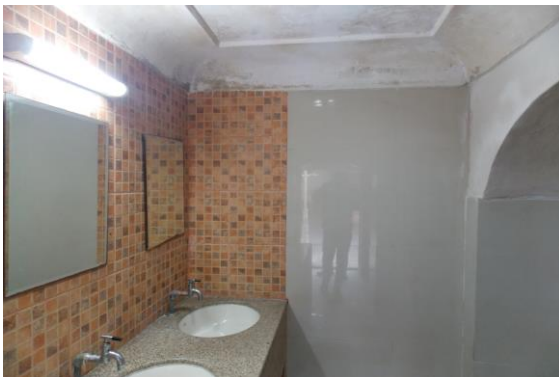
Photo 310

Damaged Portion on of Ladies Toilet of Ground Floor

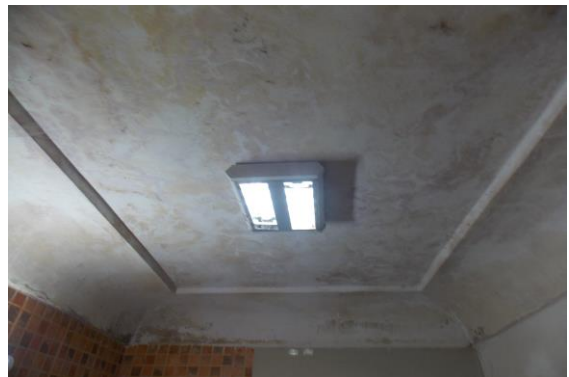
Photo 311

Dampness/Seepage on Roof of Ladies Toilet of Ground Floor

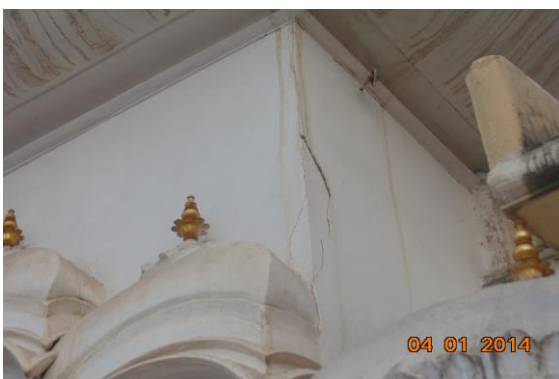
Photo 312

Peeling of Plaster on Wall No. 2 of Outer wall of main door of Part B1 Upper Ground Floor

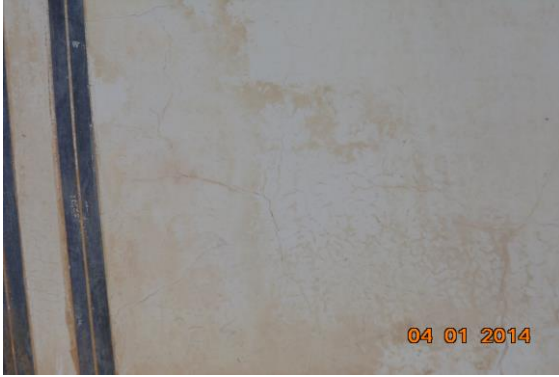
Photo 314

Dampness/Seepage on Wall No. 4 of Tomb 2 of Part B1 Upper Ground Floor

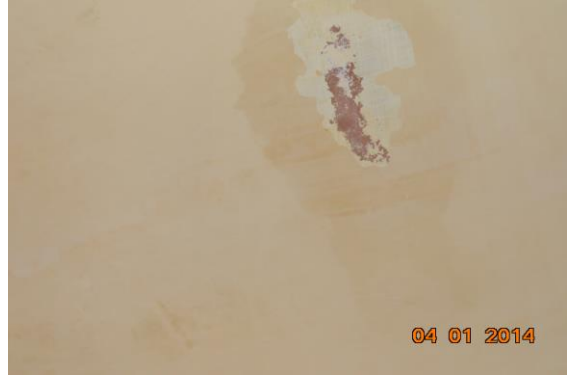
Photo 315

Dampness/Seepage on Roof of Passage 1 of Part B1 Upper Ground Floor

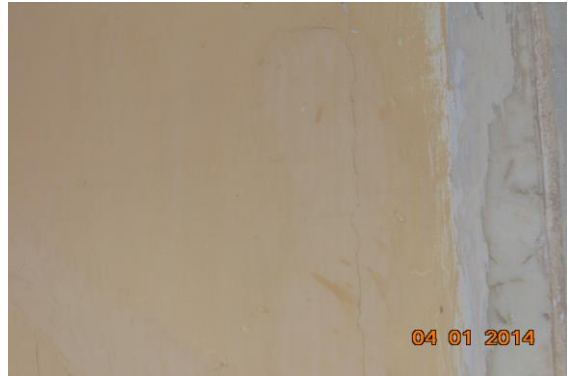
Photo 317

Plaster Crack on Wall No. 4 of Vranda 5 of Part B1 Upper Ground Floor

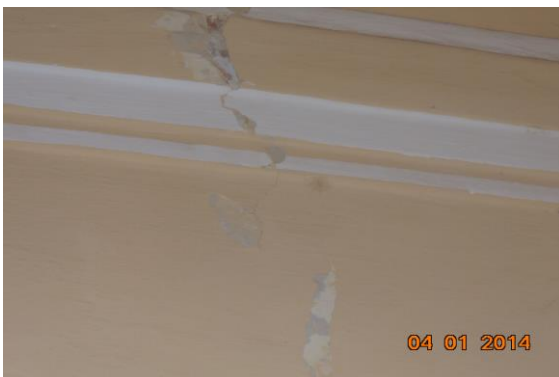
Photo 318

Peeling of Plaster on Wall No. 2 of Vranda 5 of Part B1 Upper Ground Floor
