Pre Building Condition Survey Report

Name and Address of Structure :	Badi Chopar Station Area
---------------------------------	--------------------------

Name of the Project	Contract JMRC-UG1B “Design and Construction of Tunnel between Chandpole and Badi Chouper and reverse line by Shield TBM, Underground Metro Stations at Choti Chouper and Badi Chouper by Cut and Cover Methods on East West Corridor of Jaipur Metro Rail Corporation Limited .”	
Owner :

Pre - Condition Building Survey for Construction of Underground Stations from Chandpole to Bari Chouper and reversal line

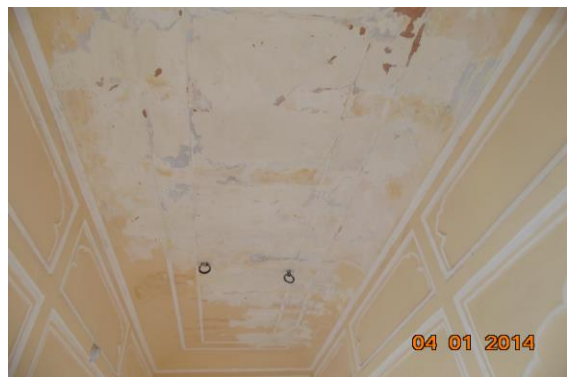
Photo 319

Dampness/Seepage on Roof of Vranda 4 of Part B1 Upper Ground Floor

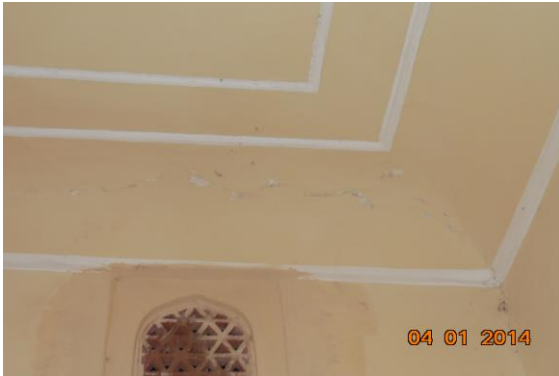
Photo 320

Dampness/Seepage on Roof of Vrandra 4 of Part B1 Upper Ground Floor

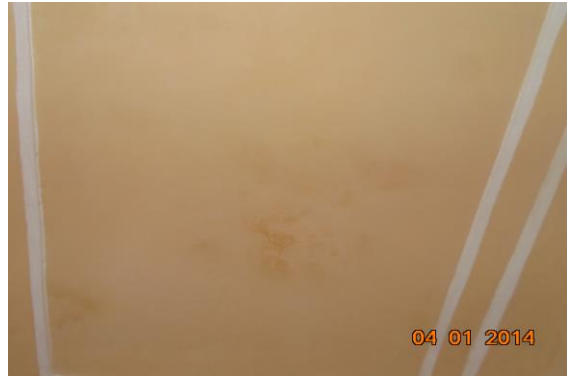
Photo 321

Dampness/Seepage on Roof of Room No. 1 of Part B1 Upper Ground Floor

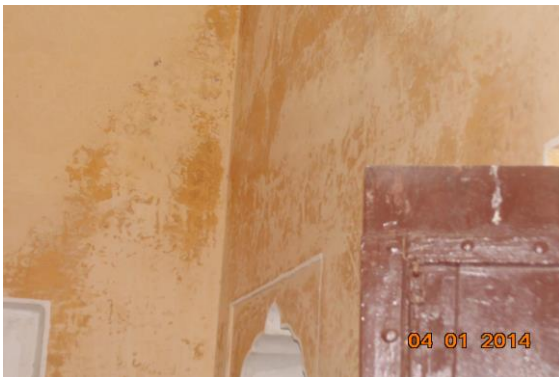
Photo 322

Dampness/Seepage on Wall No. 2 & 4 of Room No. 2 of Part B1 Upper Ground Floor

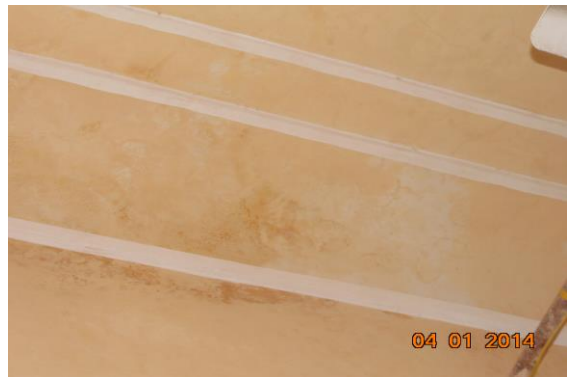
Photo 323

Dampness/Seepage on Roof & 1 of Room No. 2 of Part B1 Upper Ground Floor

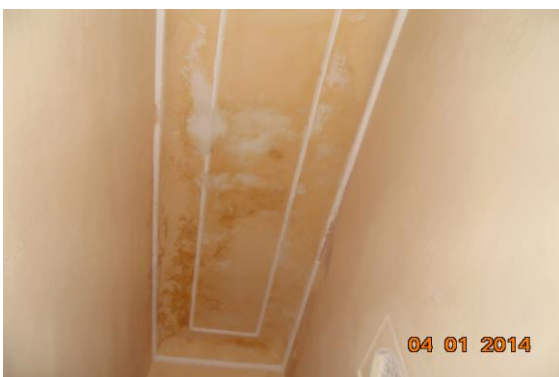
Photo 324

Dampness/Seepage on Roof of Vrandra 4 of Part B1 Upper Ground Floor

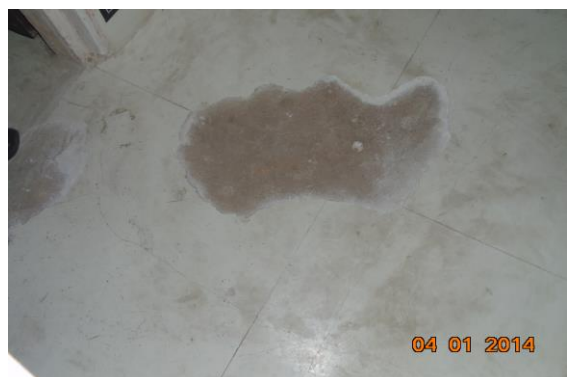
Photo 325

Peeling of Plaster on Floor of Vrandra 4 of Part B1 Upper Ground Floor

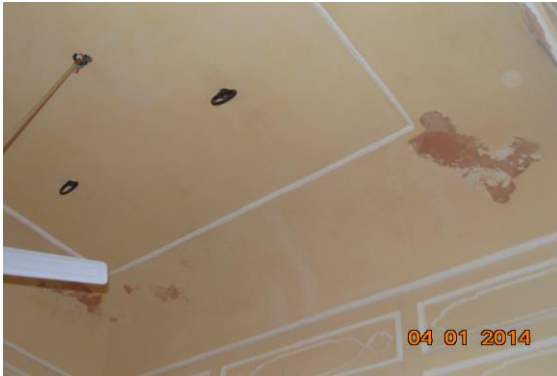
Photo 326

Peeling of Plaster on Roof of Room No. 3 of Part B1 Upper Ground Floor

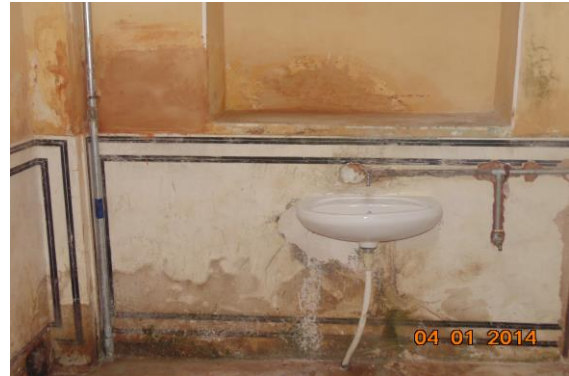
Photo 327

Damaged Portion on Wall No. 1 of Open Area Lobby of Part B1 Upper Ground Floor

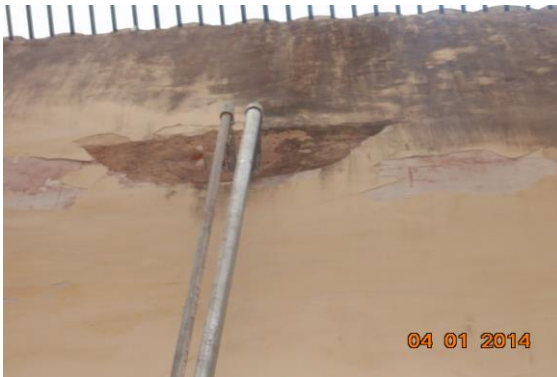
Photo 328

Peeling of Plaster on Wall No. 2 of Open Area Lobby of Part B1 Upper Ground Floor

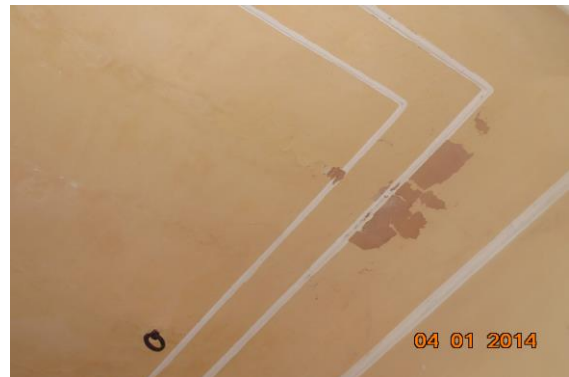
Photo 329

Peeling of Plaster on Roof of Toilet of Part B1 Upper Ground Floor

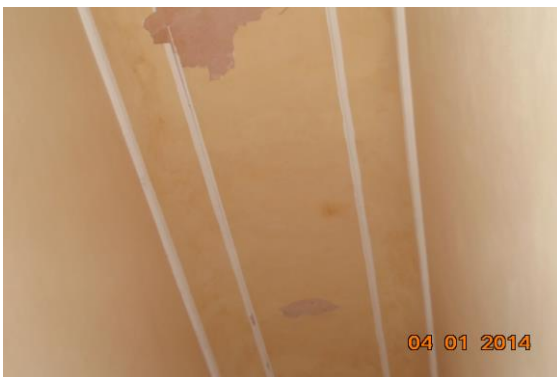
Photo 330

Peeling of Plaster on Roof of Passage of Part B1 Upper Ground Floor

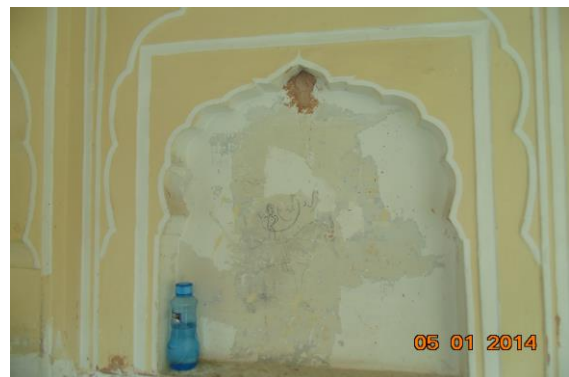
Photo 331

Peeling of Plaster on Wall No. 1 of Vrandra 6 of Part B1 Upper Ground Floor

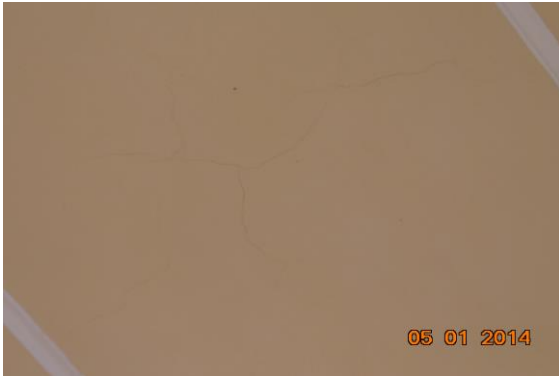
Photo 332

Peeling of Plaster on Wall No. 1 of Vrandra 6 of Part B1 Upper Ground Floor

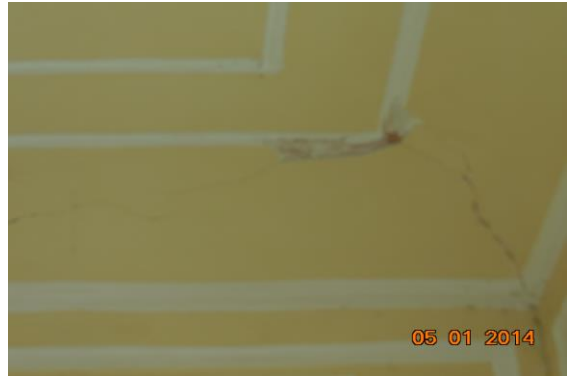
Photo 333

Peeling of Plaster on Roof & Wall No. 4 of Vrandra 6 of Part B1 Upper Ground Floor

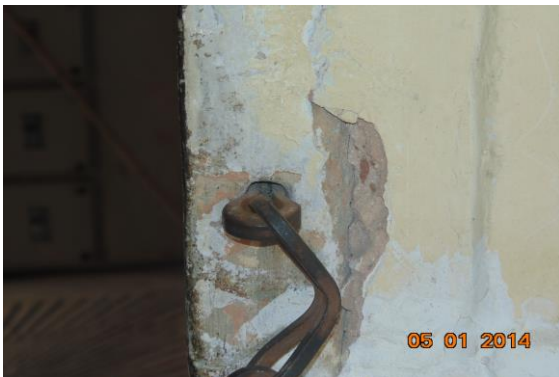
Photo 334

Peeling of Plaster on Wall No. 1 of Vrandra 6 of Part B1 Upper Ground Floor

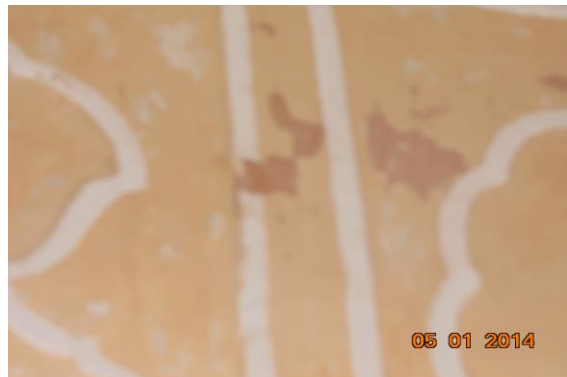
Photo 335

Peeling of Plaster on Wall No. 3 of Room No. 4 of Part B1 Upper Ground Floor

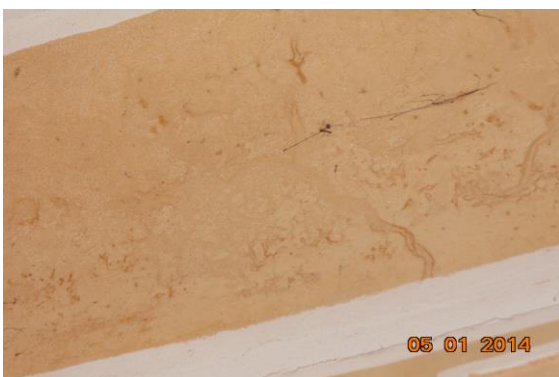
Photo 336

Dampness/Seepage on Roof of Room No. 4 of Part B1 Upper Ground Floor

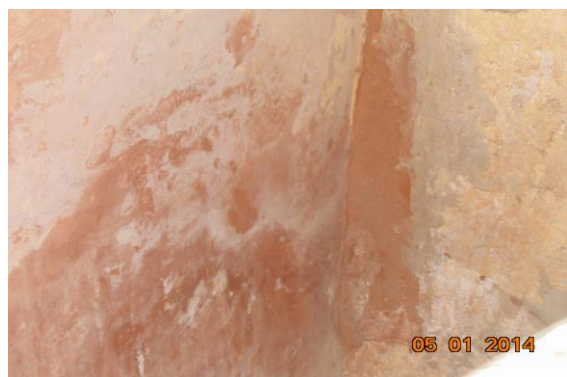
Photo 337

Peeling of Plaster on Wall No. 2 & 3 of Store 1 of Part B1 Upper Ground Floor

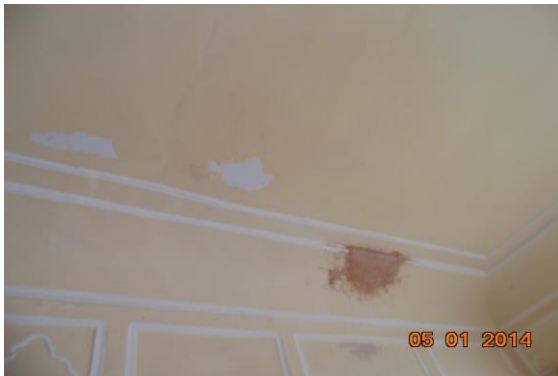
Photo 338

Damaged Portion on Roof of Vrandha 8 of Part B1 Upper Ground Floor

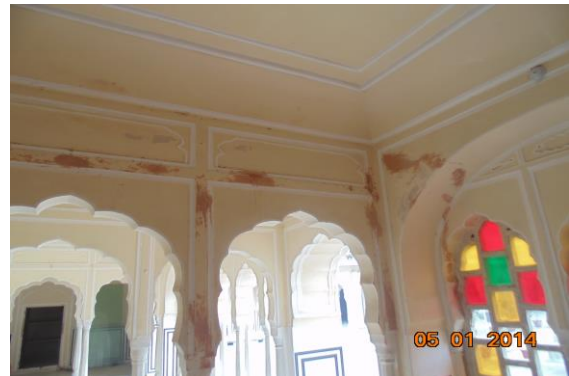
Photo 339

Damaged Portion on Wall No. 1 & 3 of Vrandha 8 of Part B1 Upper Ground Floor

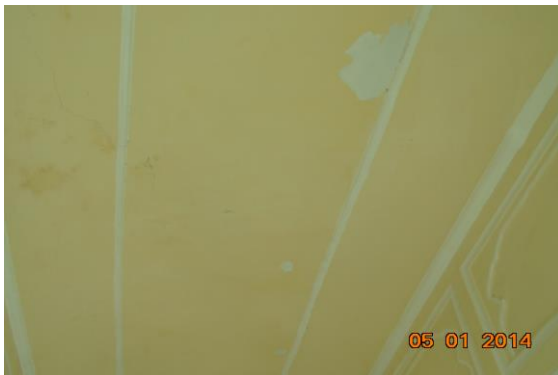
Photo 340

Plaster Crack on Roof of Vrandha 9 of Part B1 Upper Ground Floor

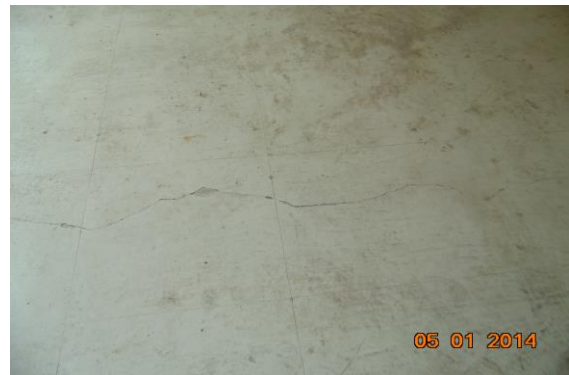
Photo 341

Plaster Crack on Floor of Vrandha 10 of Part B1 Upper Ground Floor

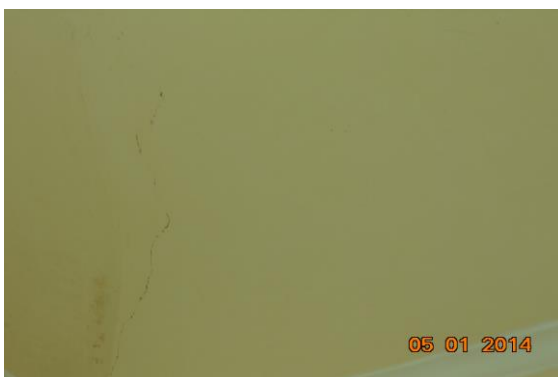
Photo 342

Plaster Crack on Roof of Vrandha 10 of Part B1 Upper Ground Floor

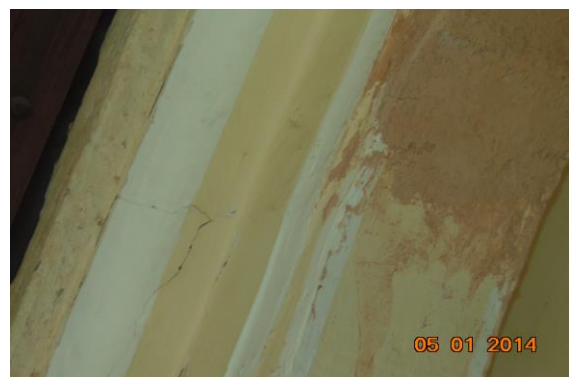
Photo 343

Damaged Portion on Wall No. 1 of Vrandha 10 of Part B1 Upper Ground Floor

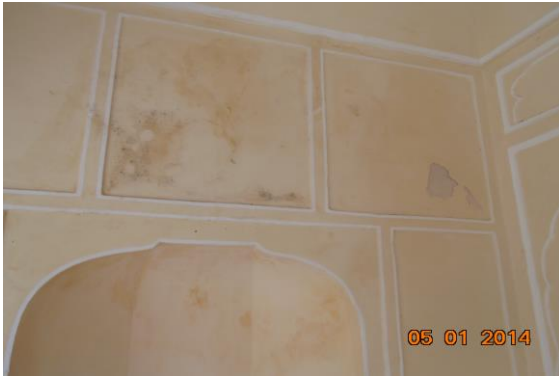
Photo 344

Dampness/Seepage on Wall No. 1 of Vranda 12 of Part B1 Upper Ground Floor

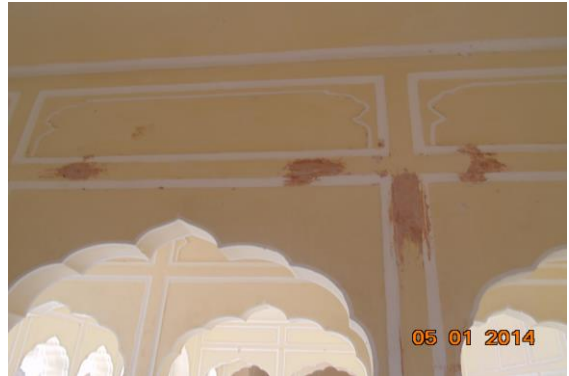
Photo 345

Damaged Portion on Wall No. 3 of Vranda 12 of Part B1 Upper Ground Floor

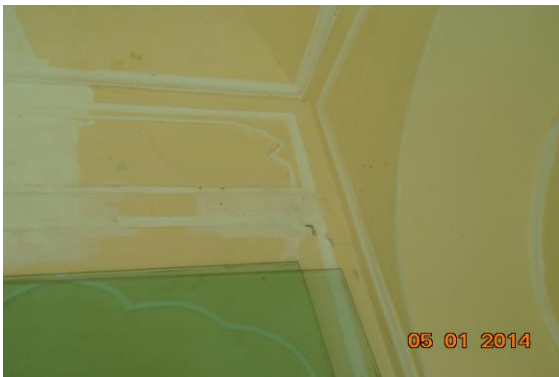
Photo 346

Plaster Crack on Wall No. 4 of Vranda 12 of Part B1 Upper Ground Floor

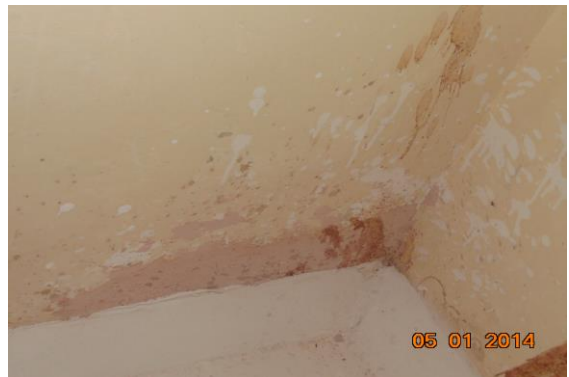
Photo 347

Dampness/Seepage on Wall No. 1 & 3 of Store 2 of Part B1 Upper Ground Floor

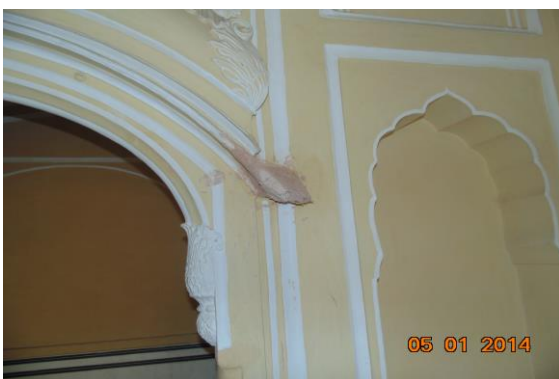
Photo 348

Damaged Portion on Wall No. 4 of Room No. 9B of Part B1 Upper Ground Floor

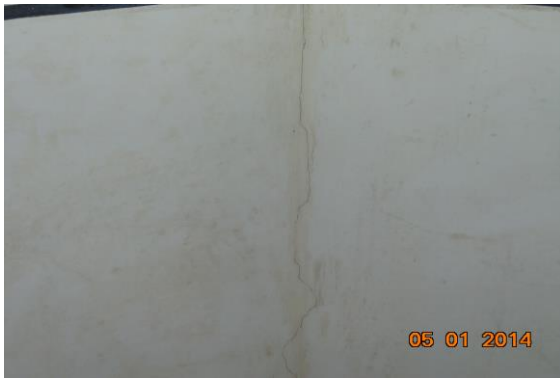
Photo 350

Plaster Crack on Wall No. 2 of Room No. 5 of Part B1 Upper Ground Floor

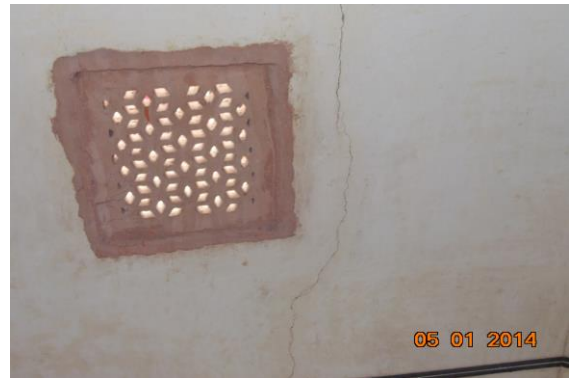
Photo 351

Plaster Crack on Wall No. 4 of Balcony 5 of Part B1 Upper Ground Floor

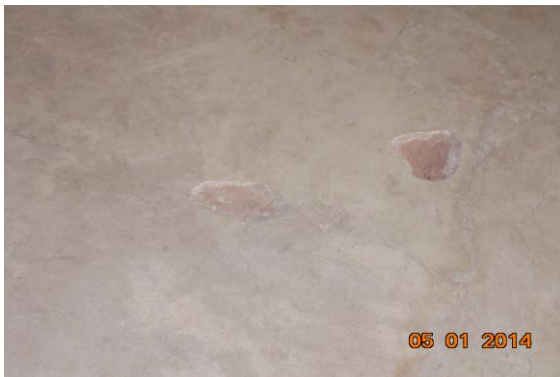
Photo 352

Peeling of Plaster on Floor of Hall No. 2 of Part B1 Upper Ground Floor

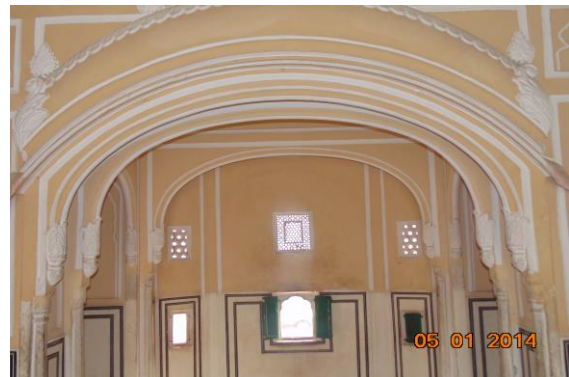
Photo 353

Damaged Portion on Wall No. 4 of Hall No. 2 of Part B1 Upper Ground Floor

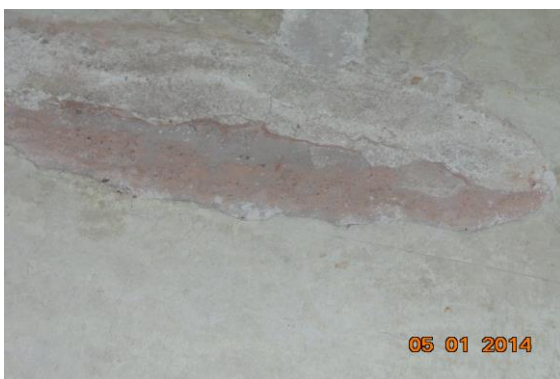
Photo 354

Peeling of Plaster on Floor of Vranda 14 of Part B1 Upper Ground Floor

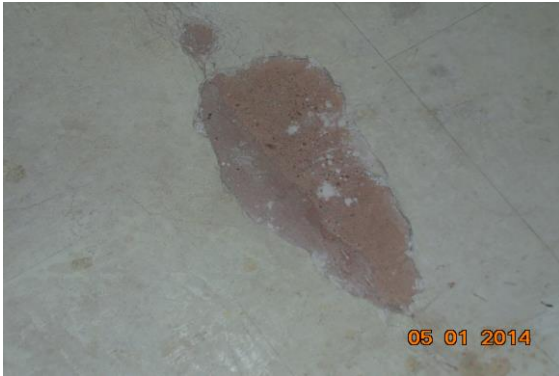
Photo 356

Peeling of Plaster on Floor of Room No. 8 of Part B1 Upper Ground Floor

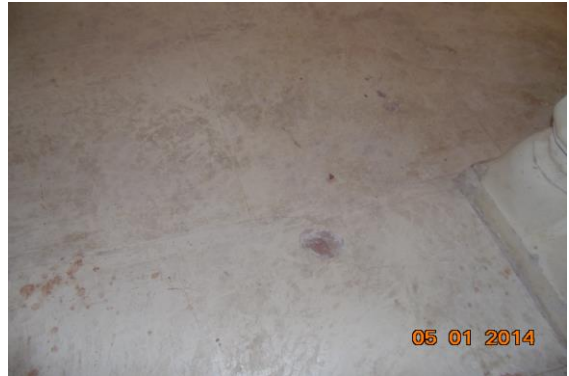
Photo 357

Peeling of Plaster on Floor of Room No. 8 of Part B1 Upper Ground Floor

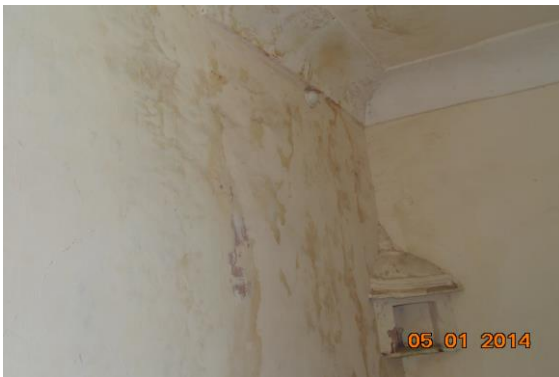
Photo 358

Dampness/Seepage on Wall No. 1 of Room No. 4 of Part B1 Upper Ground Floor

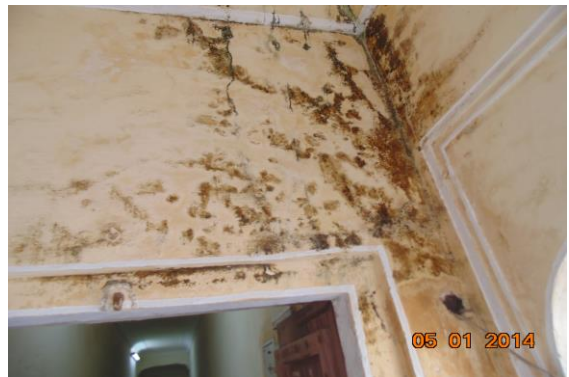
Photo 359

Dampness/Seepage on Roof & Wall No. 2 of Vrandra 21 of Part B1 Upper Ground Floor

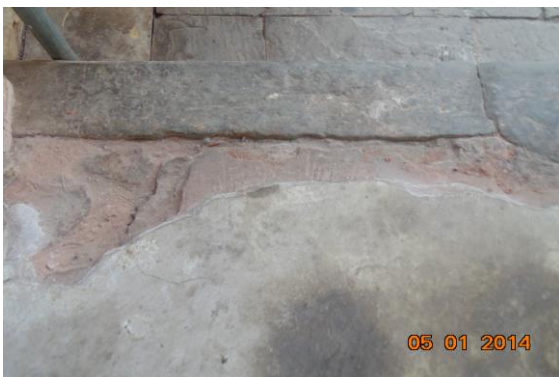
Photo 360

Dampness/Seepage on Floor of Vrandra 21 of Part B1 Upper Ground Floor

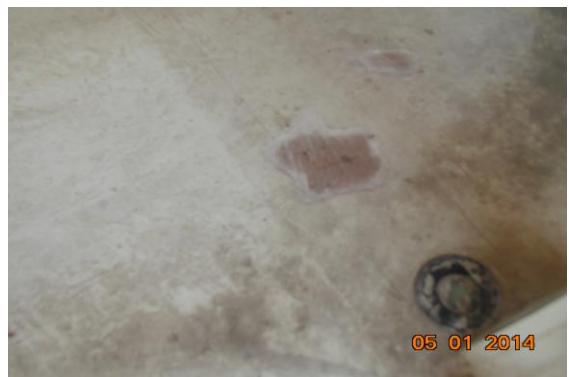
Photo 361

Peeling of Plaster on Floor of Vrandra 20 of Part B1 Upper Ground Floor

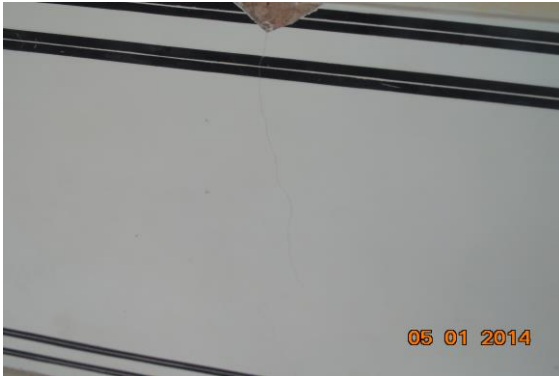
Photo 362

Peeling of Plaster on Wall No. 4 of Vranda 19 of Part B1 Upper Ground Floor

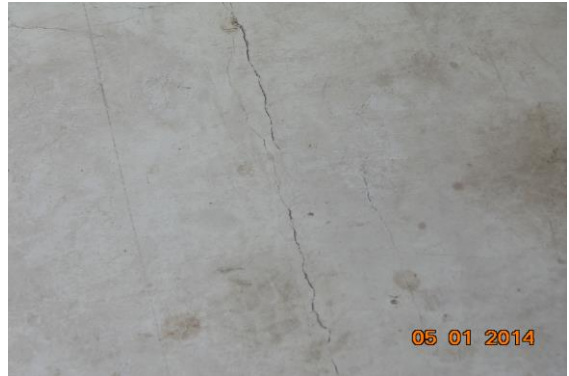
Photo 363

Plaster Crack on Floor of Vranda 18 of Part B1 Upper Ground Floor

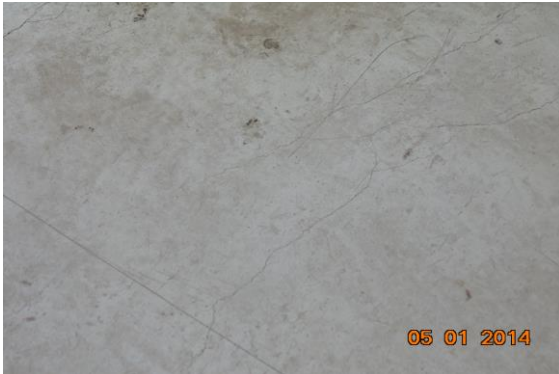
Photo 364

Plaster Crack on Floor of Vranda 17 of Part B1 Upper Ground Floor

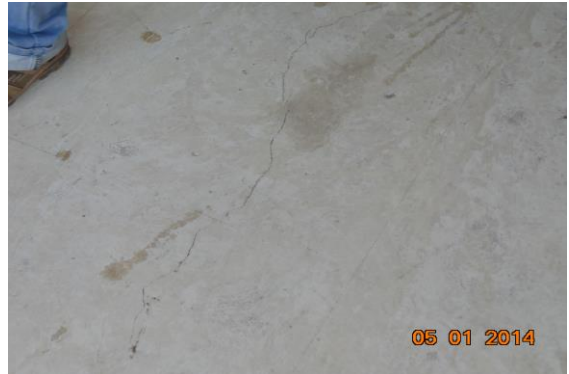
Photo 365

Plaster Crack on Floor of Vranda 16 of Part B1 Upper Ground Floor

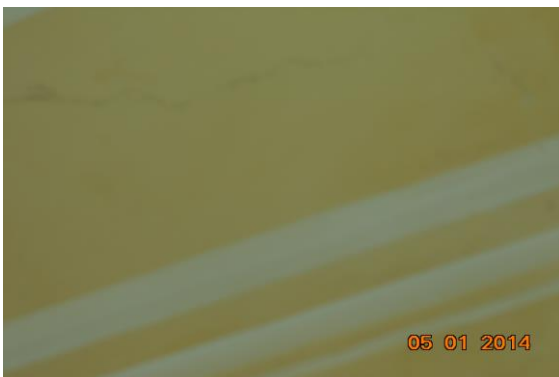
Photo 366

Plaster Crack on Roof of Vranda 15 of Part B1 Upper Ground Floor

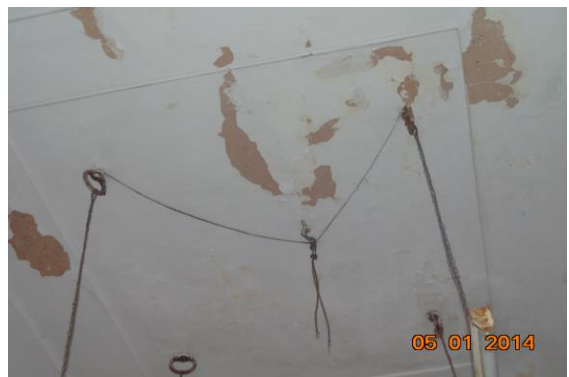
Photo 367

Peeling of Plaster on Roof of Room No. 6 of Part B1 Upper Ground Floor

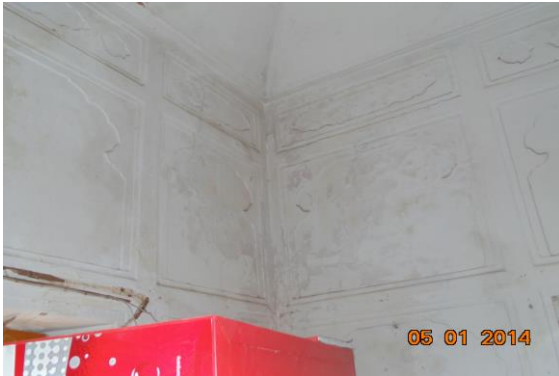
Photo 368

Dampness/Seepage on Wall No. 1 & 3 of Room No. 6 of Part B1 Upper Ground Floor

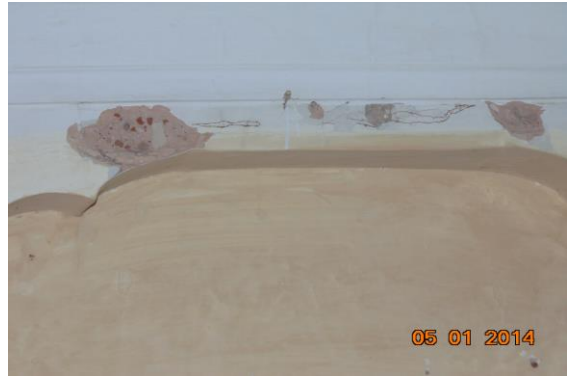
Photo 369

Peeling of Plaster on Wall No. 1 of Room No. 6 of Part B1 Upper Ground Floor

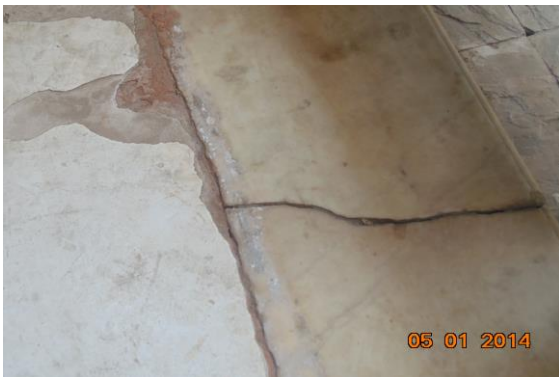
Photo 370

Damaged Portion on Floor of Vrandra 13 of Part B1 Upper Ground Floor

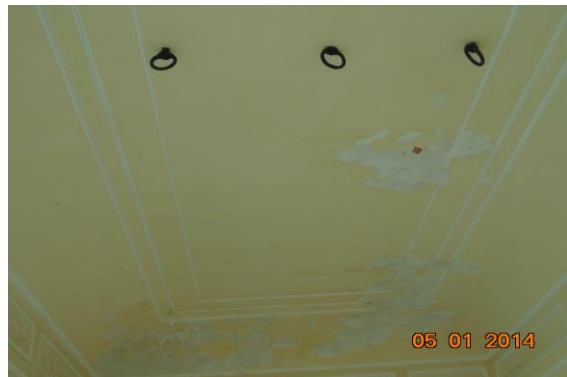
Photo 371

Peeling of Plaster on Roof of Vrandra 13 of Part B1 Upper Ground Floor

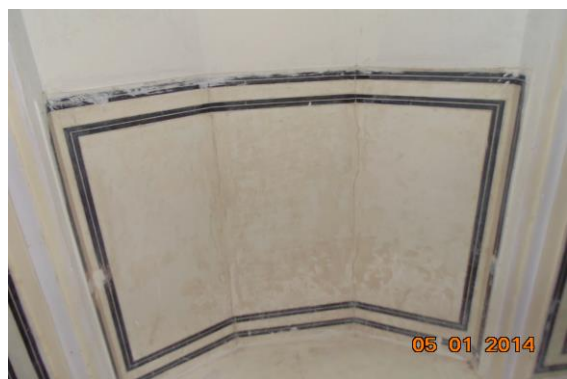
Photo 373

Dampness/Seepage on Wall No. 4 of Hall No. 1 of Part B1 Upper Ground Floor

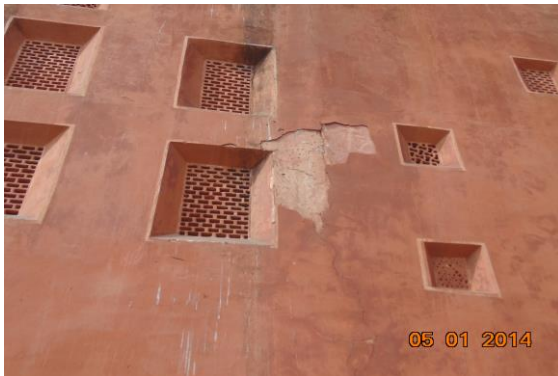
Photo 374

Peeling of Plaster on Wall No. 2 of Open Area 4 of Part B1 First Floor

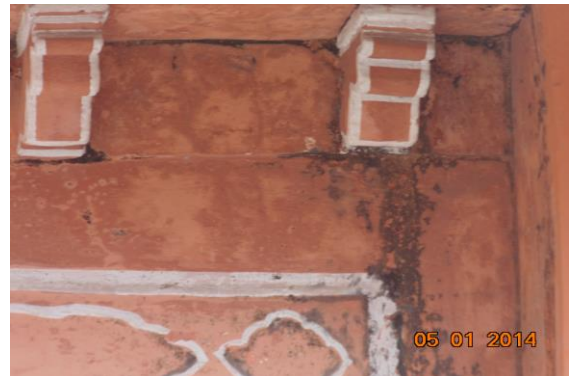
Photo 375

Dampness/Seepage on Wall No. 3 of Open Area 4 of Part B1 First Floor

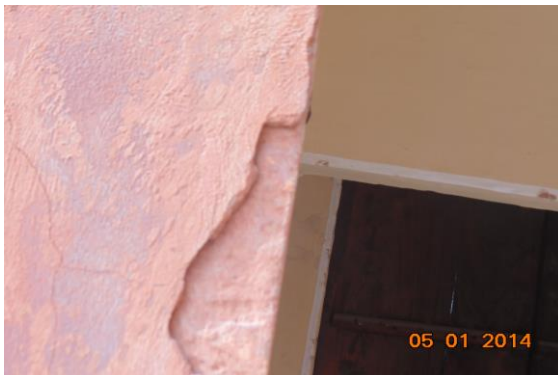
Photo 376

Plaster Crack on Wall No. 2 of Open Area 4 of Part B1 First Floor

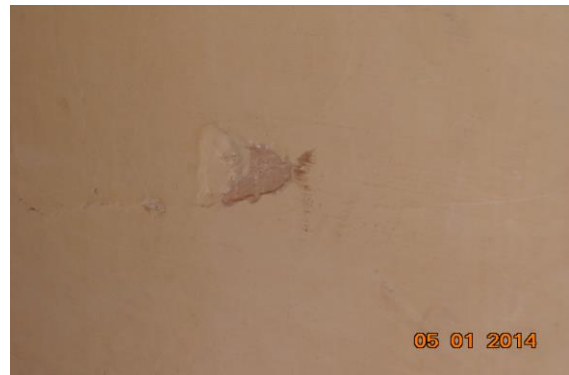
Photo 377

Peeling of Plaster on Wall No. 1 & 4 of Open Area 4 of Part B1 First Floor

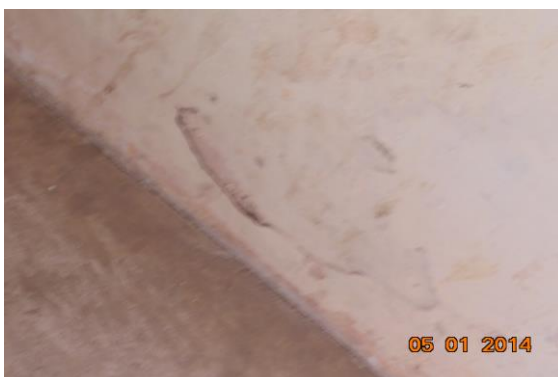
Photo 378

Peeling of Plaster on Wall No. 1 & 4 of Open Area 4 of Part B1 First Floor

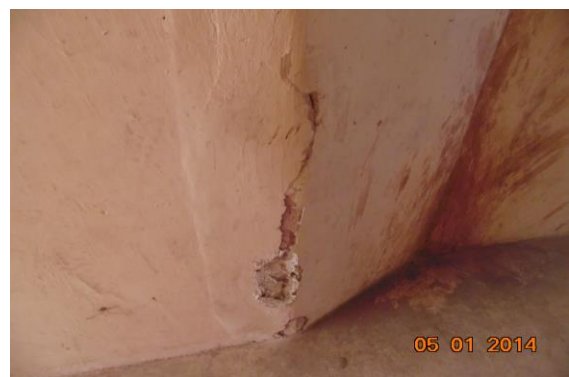
Photo 379

Plaster Crack on Wall No. 3 of Open Area 4 of Part B1 First Floor

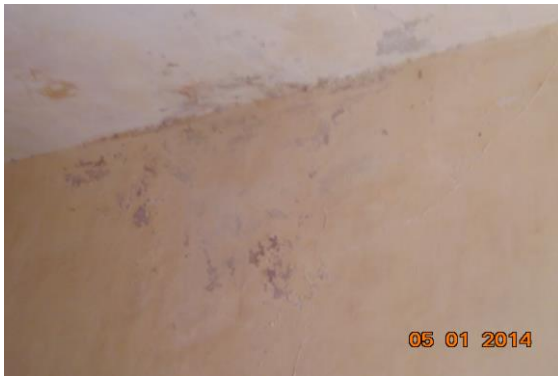
Photo 380
Peeling of Plaster on Part B1 First Floor

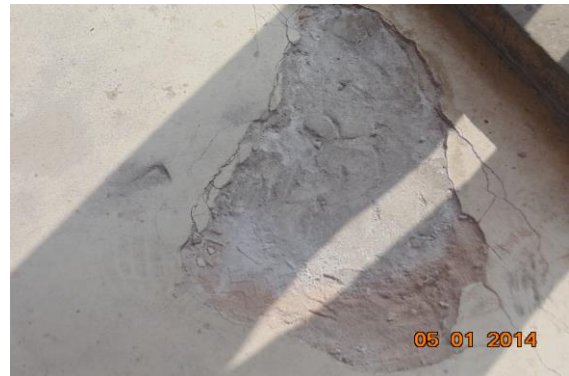
Photo 381
Peeling of Plaster on Floor of Room No. 4 of Part B1 First Floor

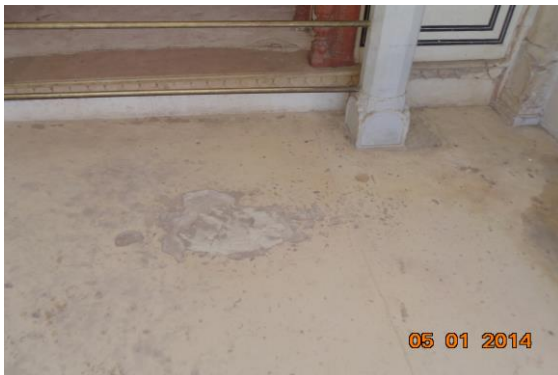
Photo 382
Peeling of Plaster on Floor of Room No. 4 of Part B1 First Floor

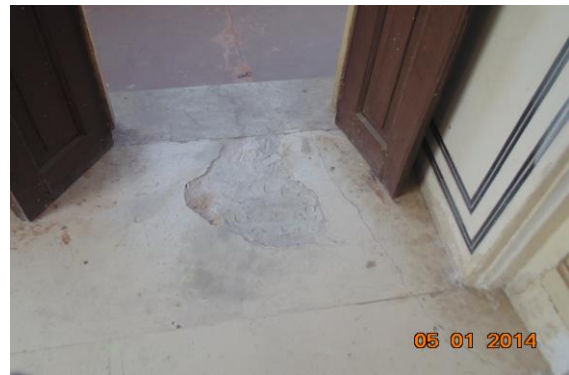
Photo 383
Peeling of Plaster on Floor of Room No. 4 of Part B1 First Floor

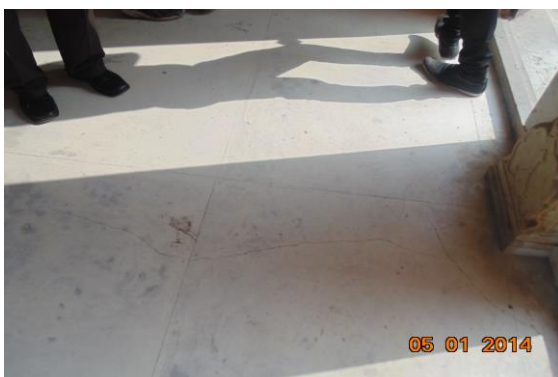
Photo 384
Plaster Crack on Floor of Room No. 4 of Part B1 First Floor

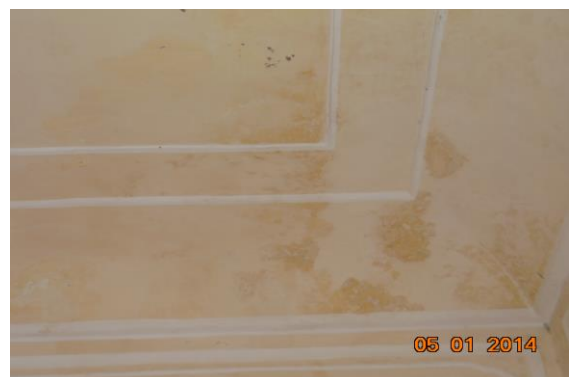
Photo 385
Dampness/Seepage on Roof of Room No. 4 of Part B1 First Floor

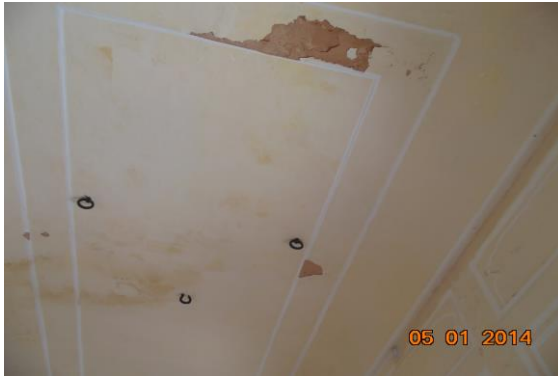
Photo 386
Dampness/Seepage on Roof of Vrandra 3 of Part B1 First Floor

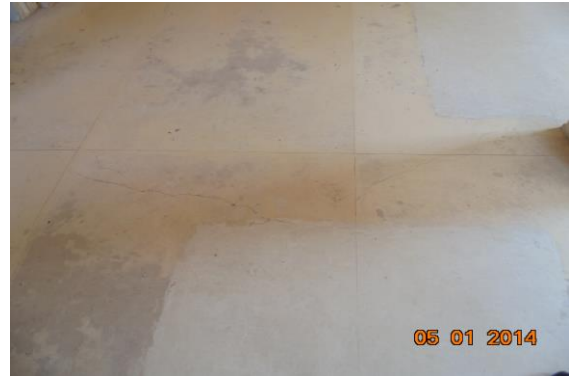
Photo 387
Plaster Crack on Floor of Vrandra 3 of Part B1 First Floor

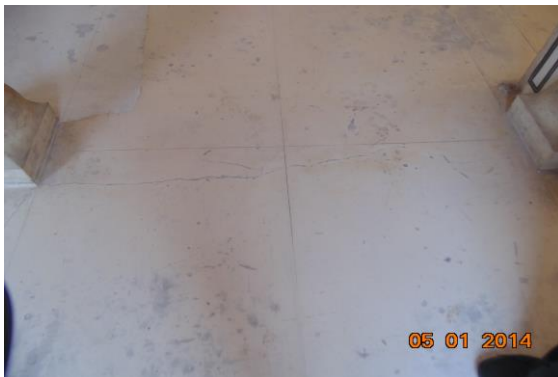
Photo 388
Plaster Crack on Floor of Vrandra 2 of Part B1 First Floor

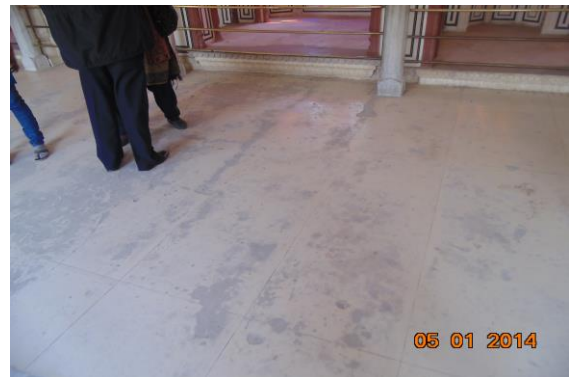
Photo 389
Dampness/Seepage on Floor of Room No. 3 of Part B1 First Floor

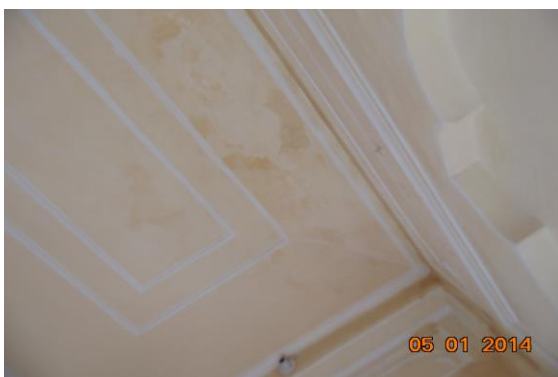
Photo 390
Dampness/Seepage on Roof of Vrandra 1 of Part B1 First Floor

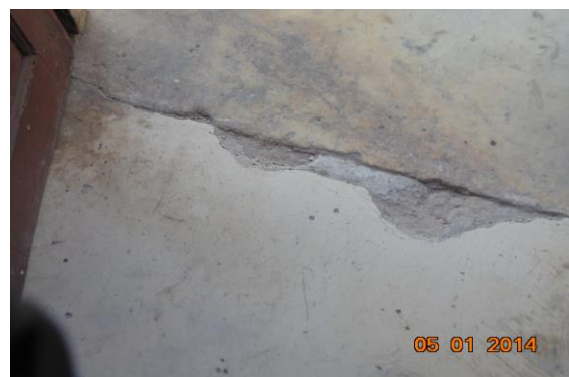
Photo 391
Peeling of Plaster on Floor of Vrandra 1 of Part B1 First Floor

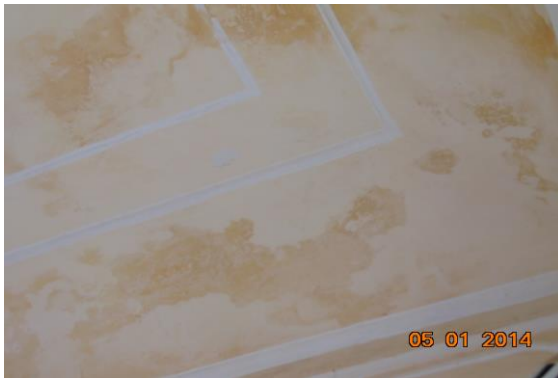
Photo 392
Dampness/Seepage on Roof of Room No. 2 of Part B1 First Floor

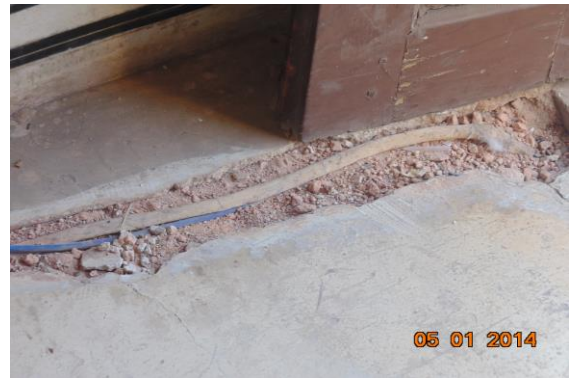
Photo 393
Peeling of Plaster on Floor of Room No. 2 of Part B1 First Floor

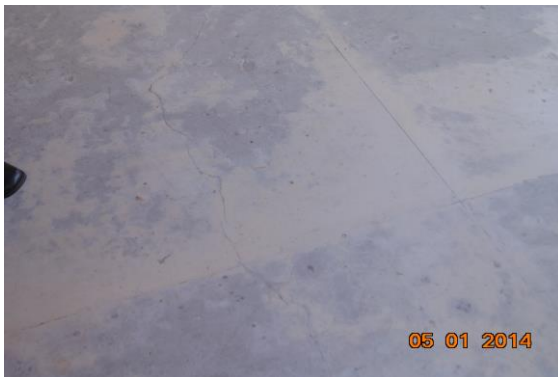
Photo 394
Plaster Crack on Floor of Room No. 2 of Part B1 First Floor

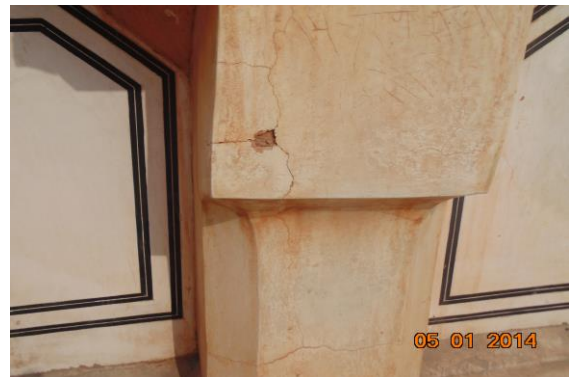
Photo 395
Plaster Crack on Wall No. 4 of Open Area 5 of Part B1 First Floor

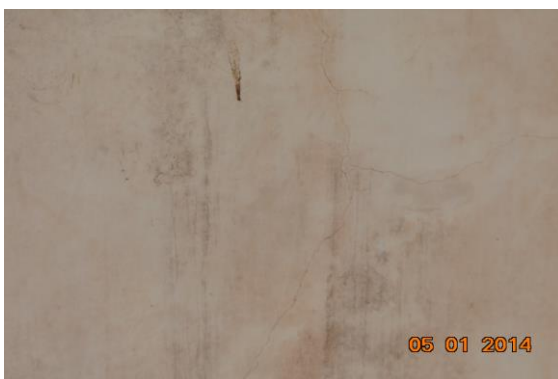
Photo 396
Plaster Crack on Wall No. 1 of Open Area 5 of Part B1 First Floor

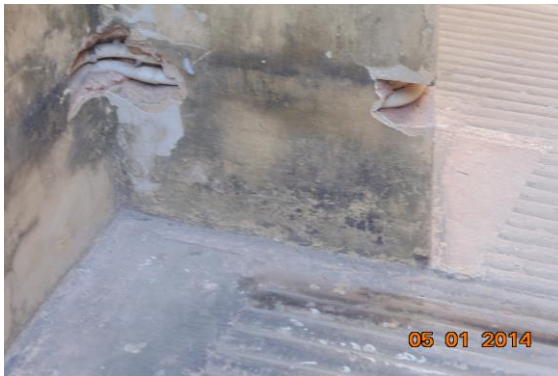
Photo 398

Peeling of Plaster on Wall No. 2 & 3 of Corner of Slope 2 of Part B1 First Floor

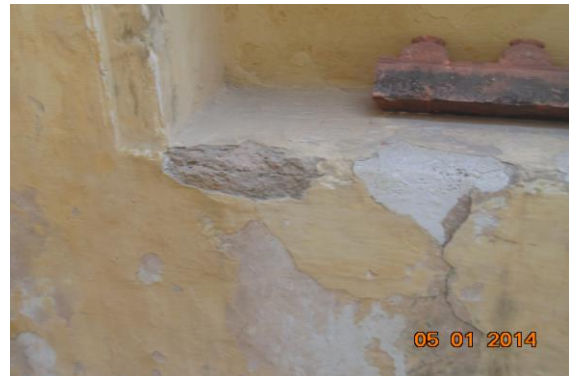
Photo 399

Peeling of Plaster on Wall No. 1 of Slope 2 of Part B1 First Floor

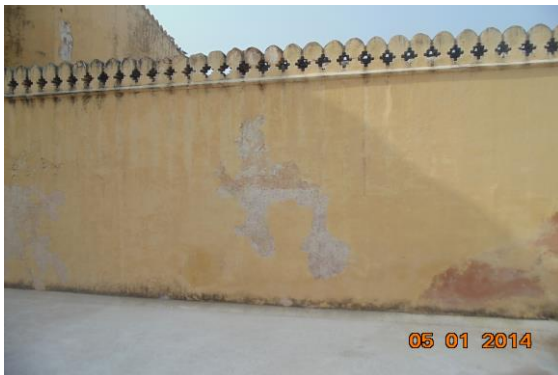
Photo 400

Peeling of Plaster on Wall No. 2 of Open Area 3 of Part B1 First Floor

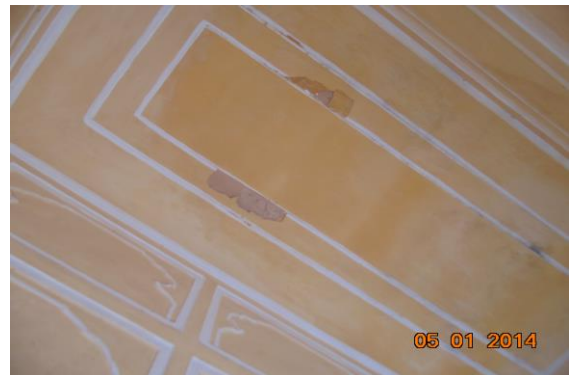
Photo 401

Peeling of Plaster on Roof of Balcony 4 of Part B1 Second Floor

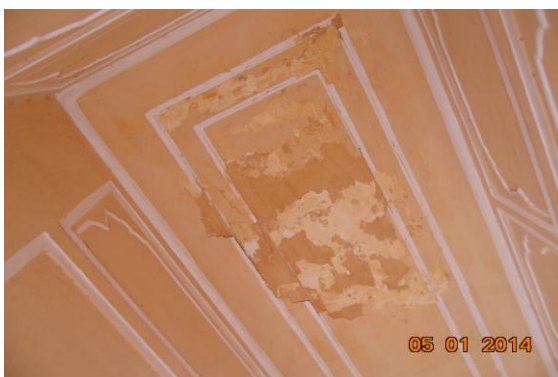
Photo 402

Peeling of Plaster on Roof of Balcony 4 of Part B1 Second Floor

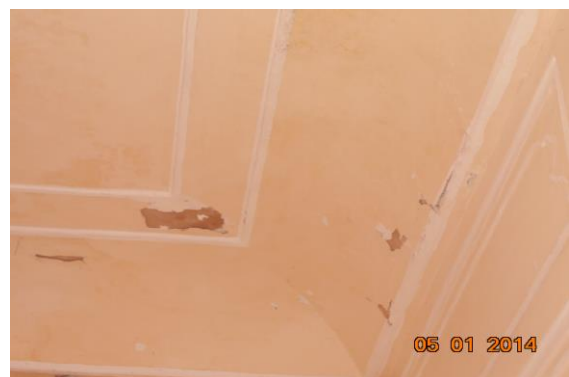
Photo 403

Dampness/Seepage on Roof of Vrandra 3 of Part B1 Second Floor

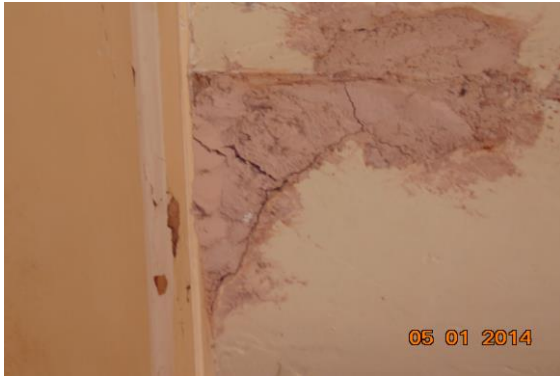
Photo 404
Damaged Portion on Wall No. 3 of Vrandra 3 of Part B1 Second Floor

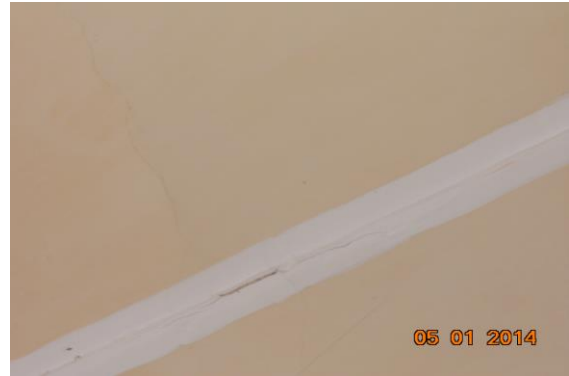
Photo 405
Plaster Crack on Roof of Room No. 1 of Part B1 Second Floor

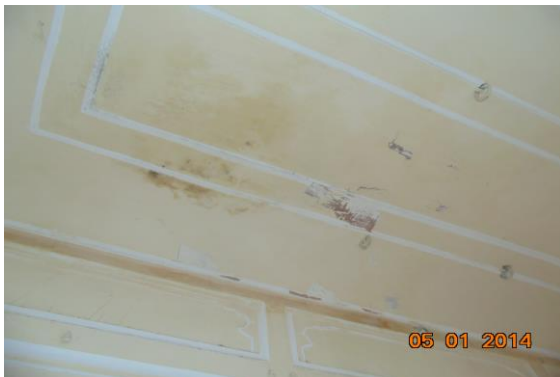
Photo 406
Dampness/Seepage on Roof of Vrandra 2 of Part B1 Second Floor

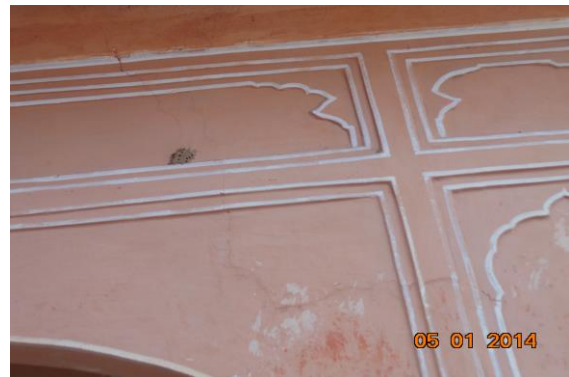
Photo 407
Plaster Crack on Wall No. 3 of Open Area 1 of Part B1 Second Floor

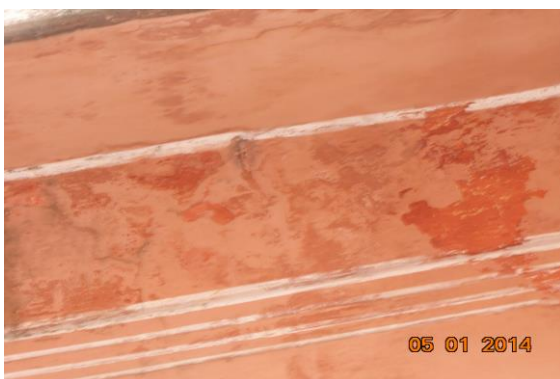
Photo 408
Dampness/Seepage on Wall No. 2 of Open Area 1 Shade of Part B1 Second Floor

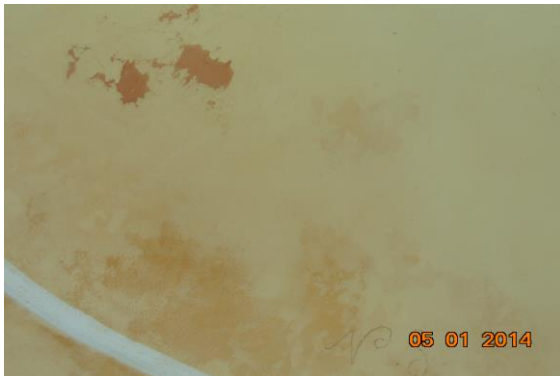
Photo 410
Dampness/Seepage on Roof of Tomb 2 of Part B1 Second Floor

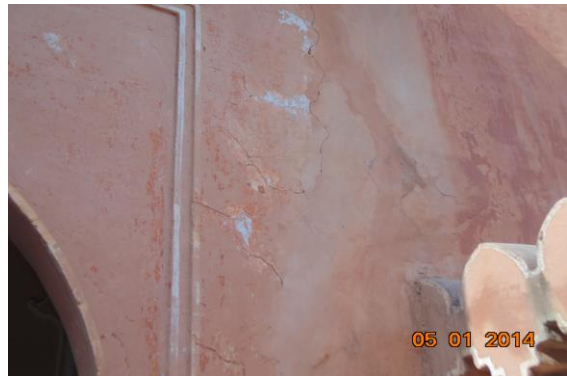
Photo 411
Plaster Crack on Wall No. 3 of Open Area 1 of Part B1 Second Floor

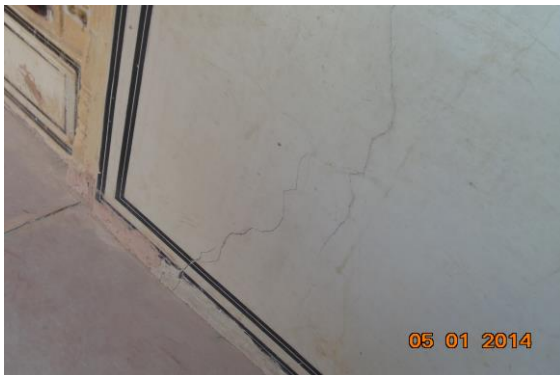
Photo 412
Plaster Crack on Wall No. 2 of Vranda 1 of Part B1 Second Floor

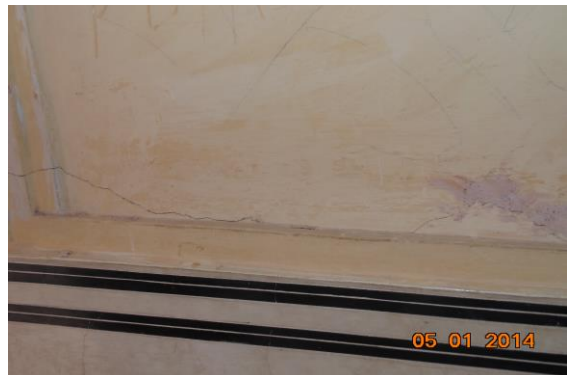
Photo 413
Plaster Crack on Wall No. 2 of Vranda 1 of Part B1 Second Floor

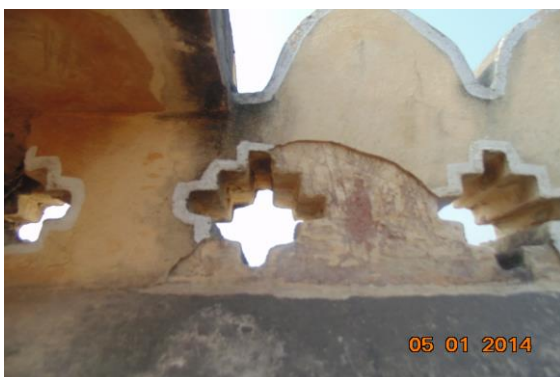
Photo 414
Peeling of Plaster on Wall No. 2 of Passage 1 of Part B1 Third Floor

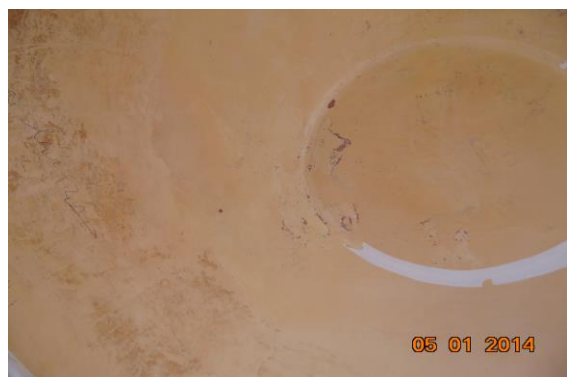
Photo 415
Peeling of Plaster on Roof of Tome 2 of Part B1 Third Floor

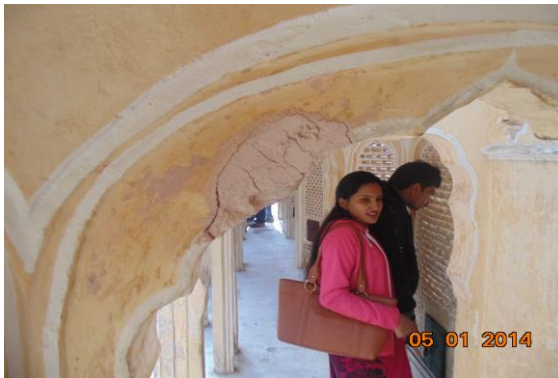
Photo 416

Damaged Portion on Wall No. 2 of Tomb 2 of Part B1 Third Floor

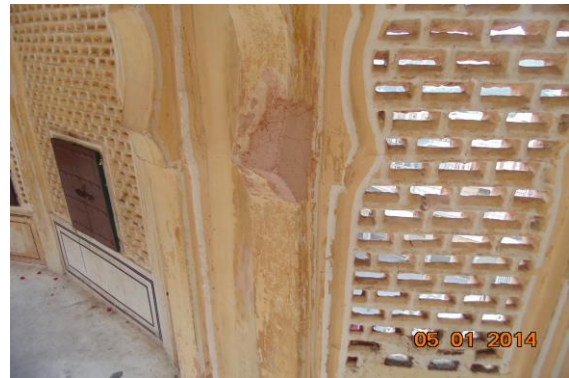
Photo 417

Damaged Portion on Wall No. 1 of Tomb 3 of Part B1 Third Floor

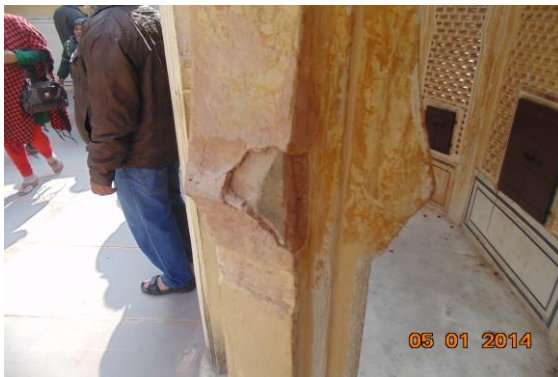
Photo 418

Damaged Portion on Wall No. 1 of Tomb 3 of Part B1 Third Floor

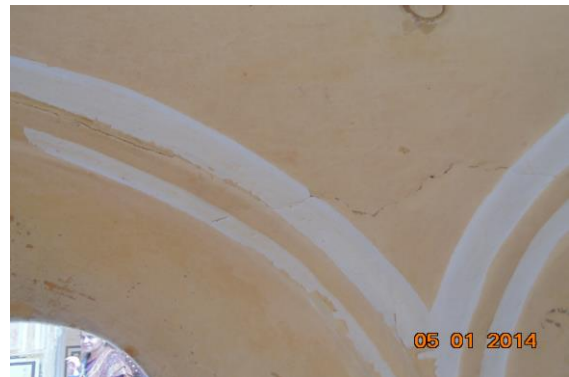
Photo 419

Plaster Crack on Wall No. 3 of Tomb 5 of Part B1 Third Floor

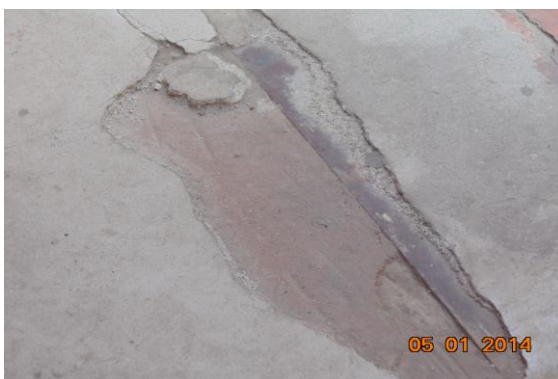
Photo 420

Peeling of Plaster on Floor of Tomb 5 of Part B1 Third Floor

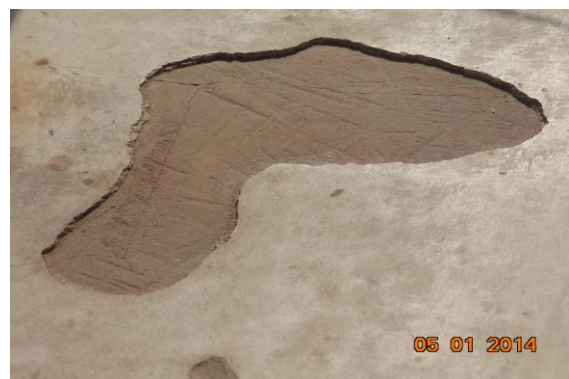
Photo 421

Peeling of Plaster on Floor of Tomb 6 of Part B1 Third Floor
