Pre Building Condition Survey Report

Name and Address of Structure :	Badi Chopar Station Area
---------------------------------	--------------------------

Name of the Project	Contract JMRC-UG1B “Design and Construction of Tunnel between Chandpole and Badi Chouper and reverse line by Shield TBM, Underground Metro Stations at Choti Chouper and Badi Chouper by Cut and Cover Methods on East West Corridor of Jaipur Metro Rail Corporation Limited .”	
Owner :

Pre - Condition Building Survey for Construction of Underground Stations from Chandpole to Bari Chouper and reversal line

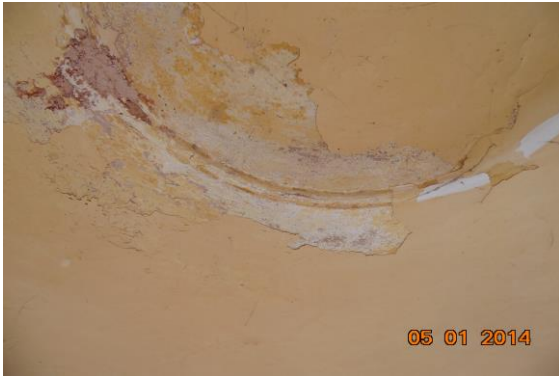
Photo 422
Peeling of Plaster on Roof of Tomb 6 of Part B1 Third Floor

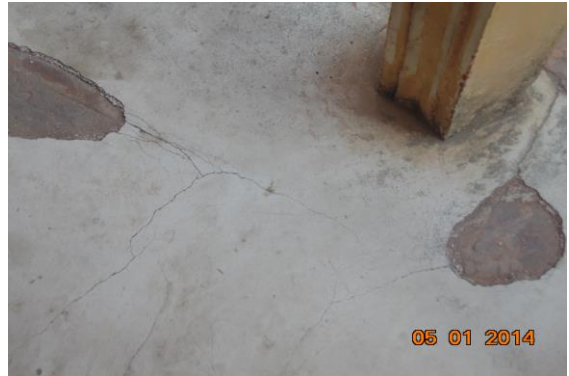
Photo 423
Peeling of Plaster on Floor of Tomb 5 of Part B1 Third Floor

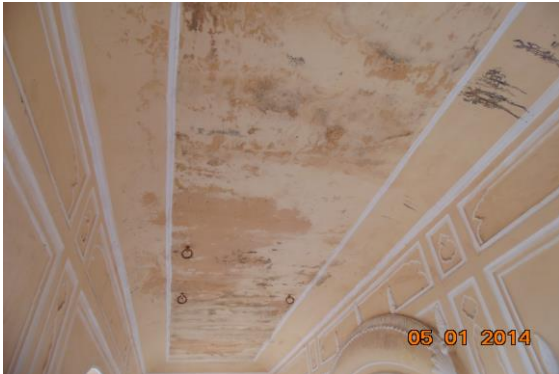
Photo 424
Dampness/Seepage on Roof of Vranda 1 of Part B1 Third Floor

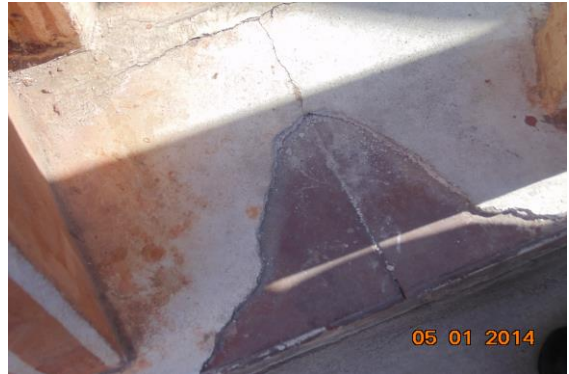
Photo 425
Peeling of Plaster on Floor of Balcony 3 of Part B1 Third Floor

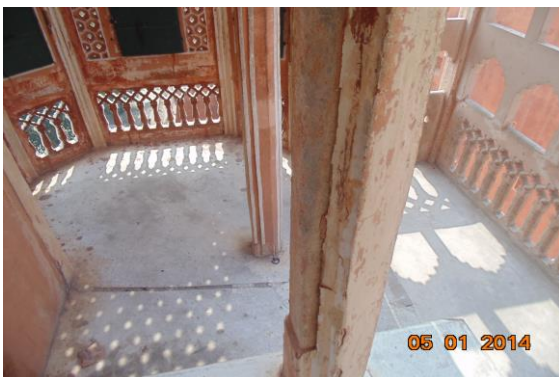
Photo 426
Dampness/Seepage on Pillor of Balcony 3 of Part B1 Third Floor

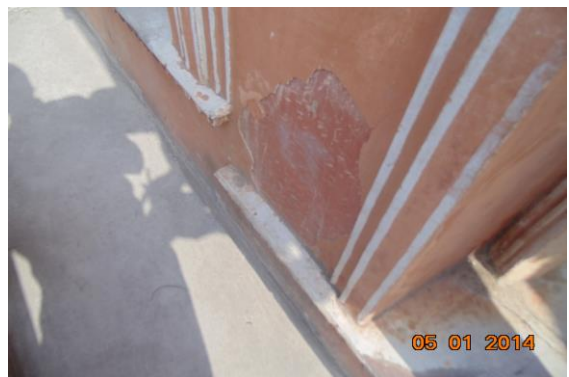
Photo 427
Peeling of Plaster on Wall No. 1 of Passage 2 of Part B1 Third Floor

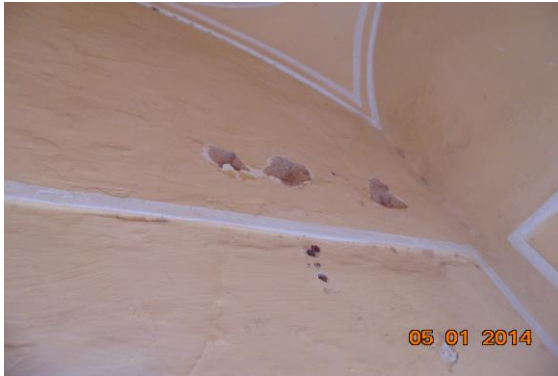
Photo 428

Peeling of Plaster on Wall No. 3 of Balcony 4 of Part B1 Third Floor

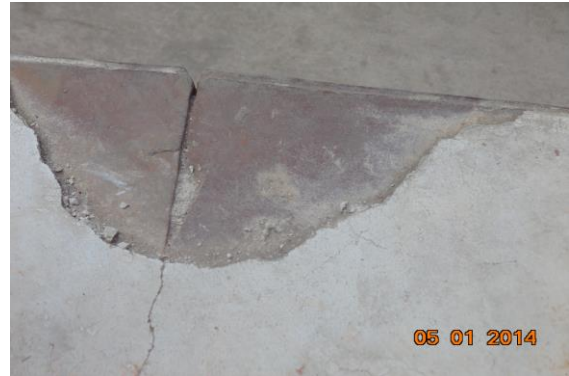
Photo 429

Peeling of Plaster on Floor of Balcony 5 of Part B1 Third Floor

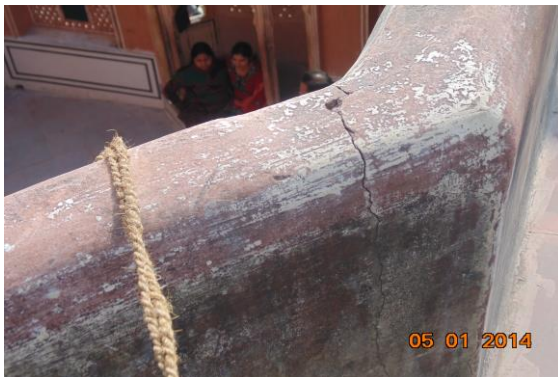
Photo 430

Plaster Crack on Wall No. 1 of Passage 3 Parapit of Part B1 Third Floor

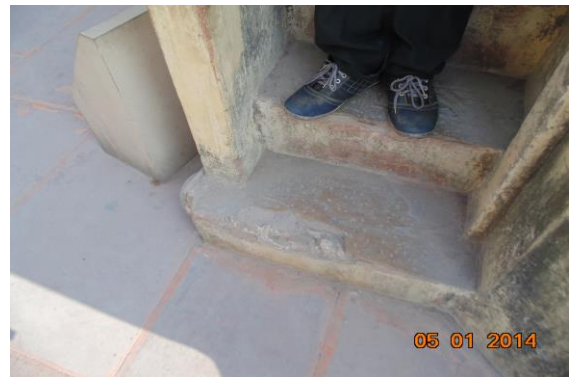
Photo 431

Dampness/Seepage on Stair Step (TF to 4th Floor) of Part B1 Third Floor

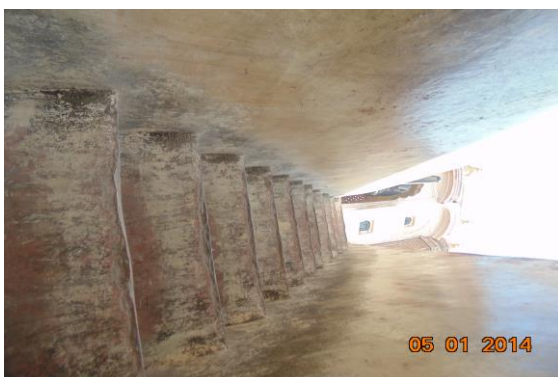
Photo 432

Dampness/Seepage on Stair Step (TF to 4th Floor) of Part B1 Third Floor

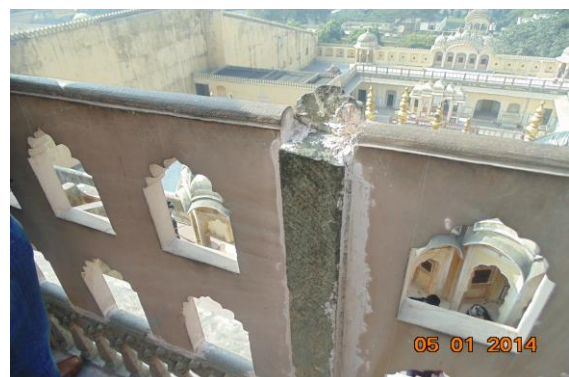
Photo 433

Dampness/Seepage on Wall No. 1 of Balcony 1 of Part B1 4th Floor

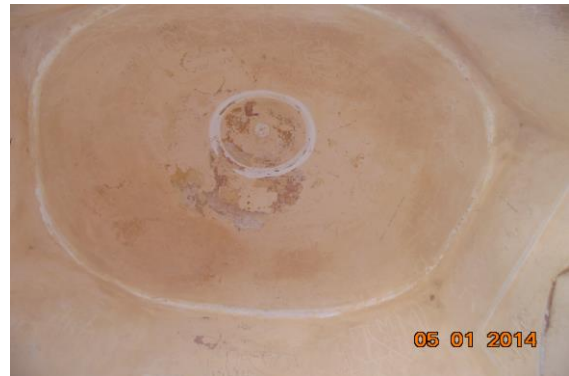
Photo 435

Dampness/Seepage on Roof of Tomb 4 of Part B1 4th Floor

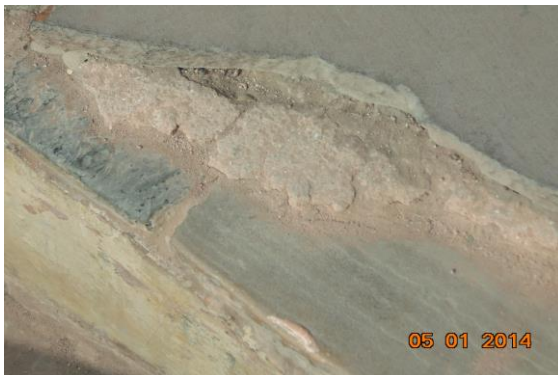
Photo 436

Dampness/Seepage on Floor of Balcony of Part B1 4th Floor

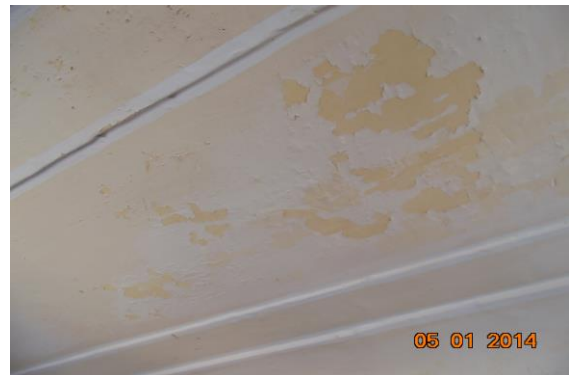
Photo 437

Dampness/Seepage on Roof of Passage 1 of Part B1 4th Floor

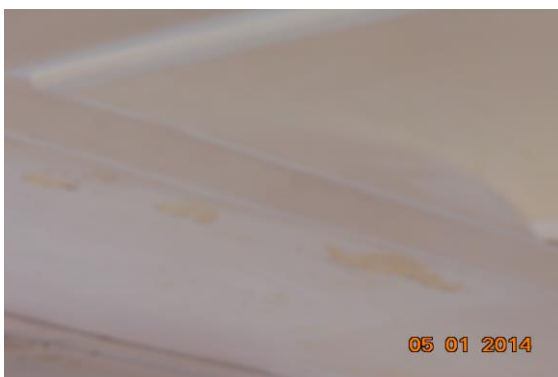
Photo 438

Dampness/Seepage on Roof of Passage 2 of Part B1 4th Floor

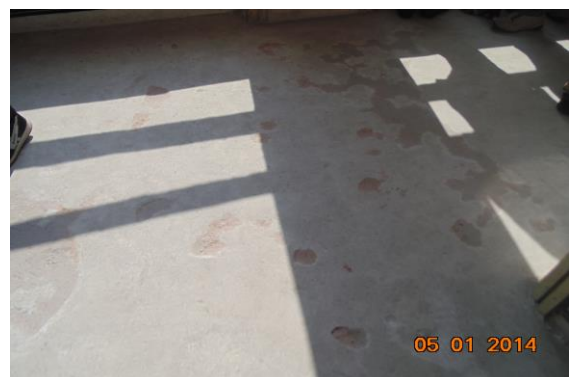
Photo 439

Dampness/Seepage on Floor of Passage 3 of Part B1 4th Floor

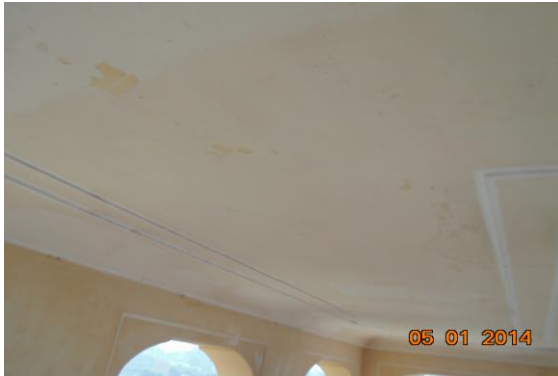
Photo 440
Dampness/Seepage on Roof of Passage 3 of Part B1 4th Floor

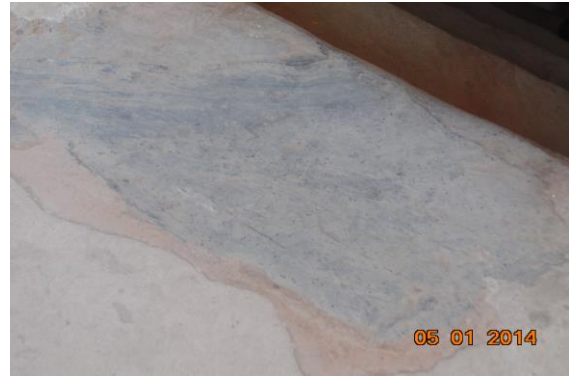
Photo 441
Peeling of Plaster on Floor of Passage 1 of Part B1 4th Floor

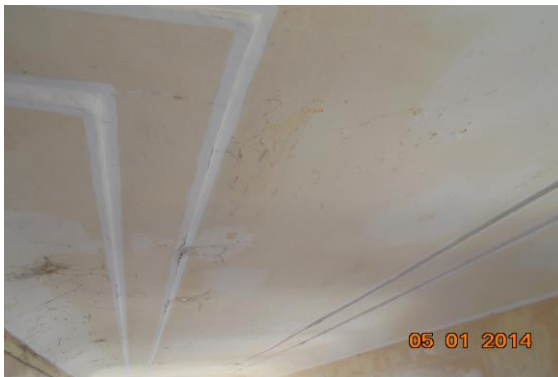
Photo 442
Dampness/Seepage on Roof of Passage 4 of Part B1 4th Floor

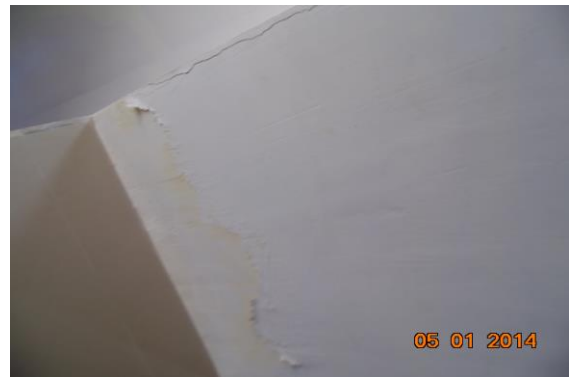
Photo 443
Dampness/Seepage on Wall No. Roof & 3 of Toilet Vranda of Lower Ground Floor

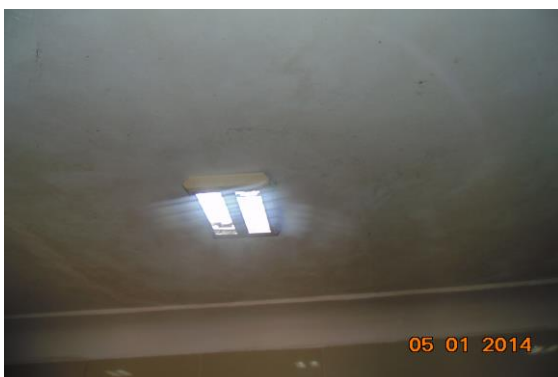
Photo 444
Damaged Portion on Roof of Vranda of Lower Ground Floor

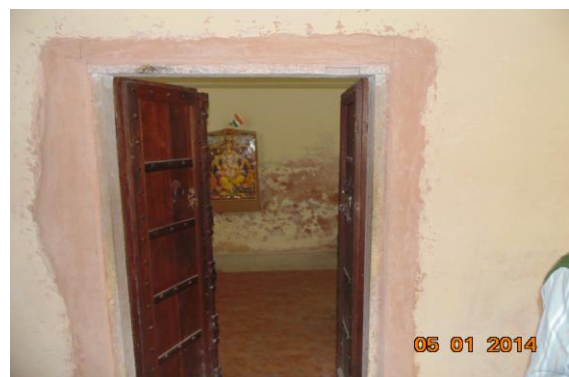
Photo 445
Damaged Portion on Wall No. 2 of Room No. 1 of Lower Ground Floor

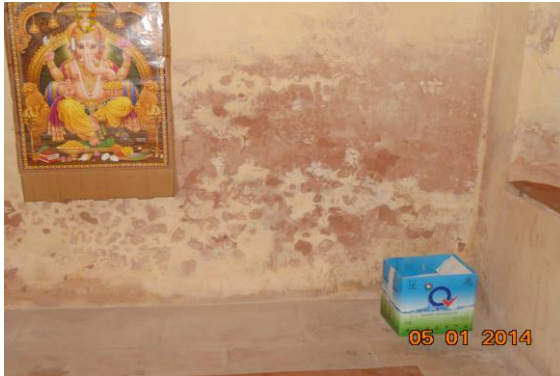
Photo 446

Dampness/Seepage on Wall No. 4 of Room No. 1 of Lower Ground Floor

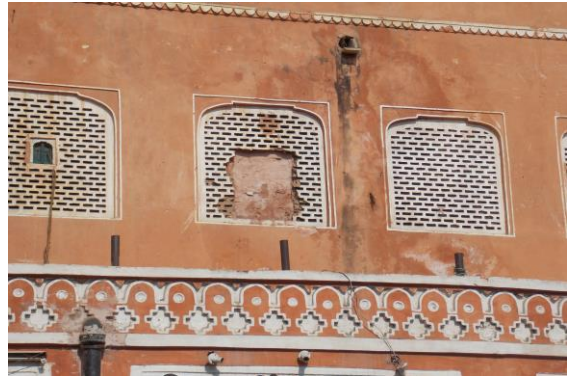
Photo 447

Peeling of Plaster on Right Side Window From R/S View of Lower Ground Floor

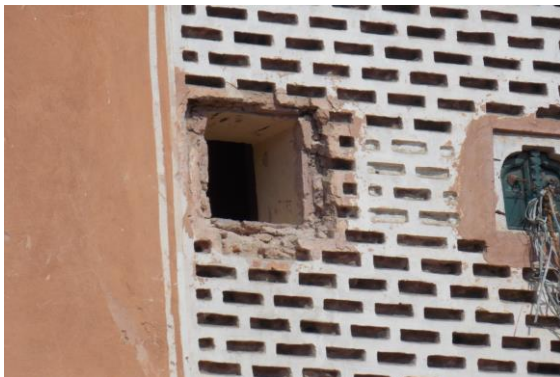
Photo 448

Peeling of Plaster on From Back Side

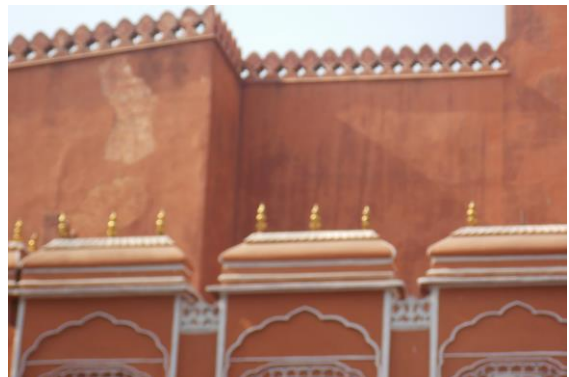
Photo 449

Peeling of Plaster on of Back Side of Hawa Mahal of FF & SF

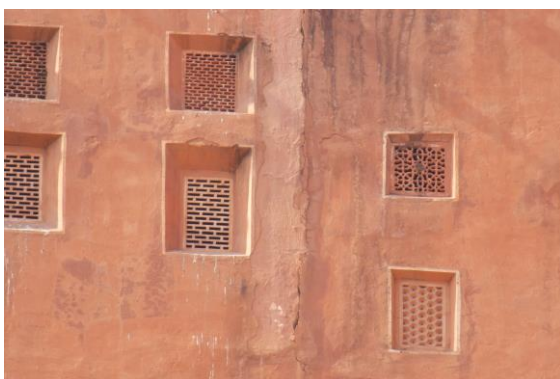
Photo 450

Peeling of Plaster on Back Side of Hawa Mahal Near ATM R/S of Ground Floor

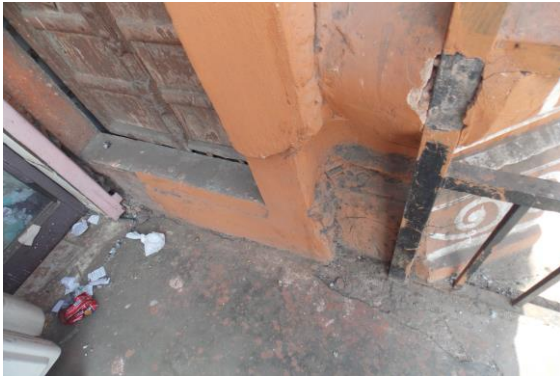
Photo 452
Peeling of Plaster

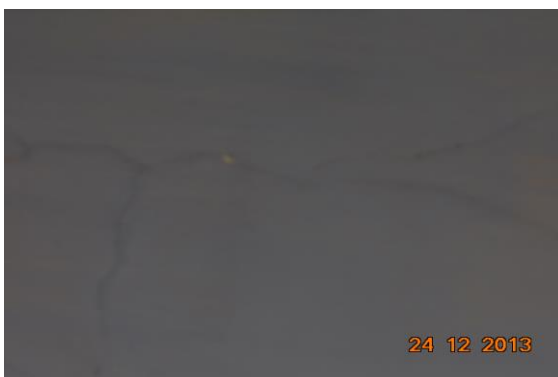
Photo 17

Inclined Crack on Wall No. 4 & Roof of Varanda, Shahid Amit Bhardwaj School, First Floor, Approx. Width = 3mm, Approx. Length = 5.3m. Distance from Wall No.1 = 0.3m, Height from Floor = 1.7m.

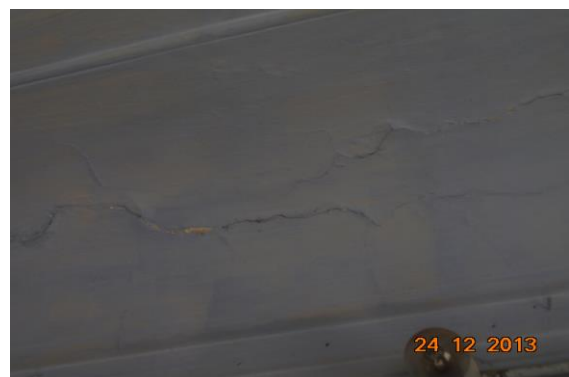
Photo 18

Inclined Crack on Wall No. 4 & Roof of Varanda, Shahid Amit Bhardwaj School, First Floor Approx. Width = 2mm, Approx. Length = 3m. Distance from Wall No 2 = 2.5m Height from Floor = 2m

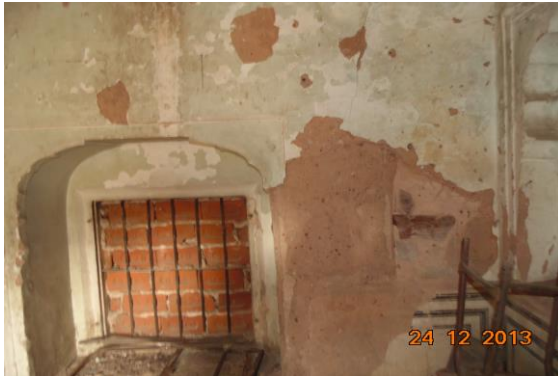
Photo 19

Inclined Crack on Wall No. 4 of Hall No. 4 (Part B), Shahid Amit Bhardwaj School, Second Floor
Approx. Width = 1mm, Approx. Length = 1.5m.
Distance from Wall No 2 = 2.5m. Height from Floor = 0.8m.

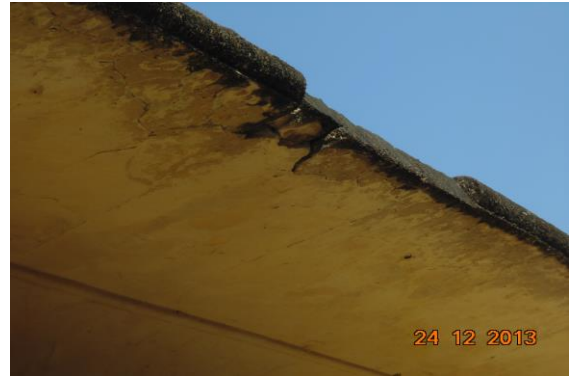
Photo 20

Inclined Crack on Wall No. 2 & Shade of Open Sky, Second Floor,
Approx. Width = 1mm, Approx. Length = 3m.
Distance from Wall No.3 = 1.5m, Height from Floor = 6m.

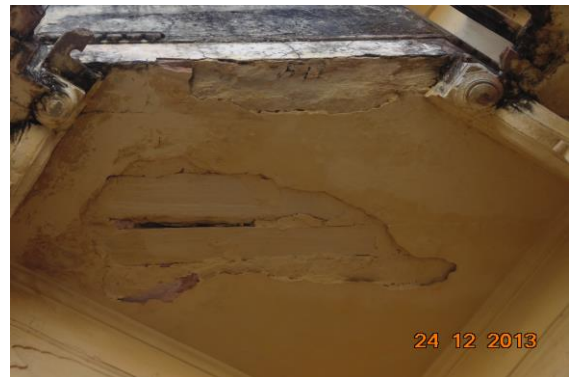
Photo 21

Inclined Crack on Wall No. 4 of Balcony, First Floor, Approx. Width = 5mm, Approx. Length = 3m.
Distance from Wall No.1 = 7.5m, Height from Floor = 7m.

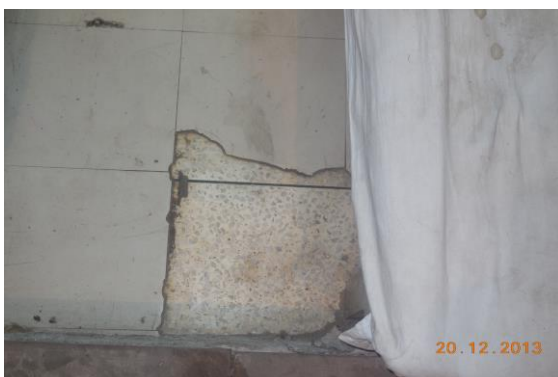
Photo 22

Damaged Portion on Floor of Shop No. 4 of Ground Floor

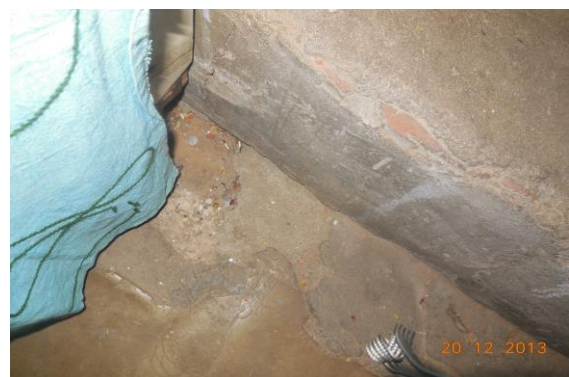
Photo 23

Peeling of Plaster on Floor of Shop No. 3 of Ground Floor

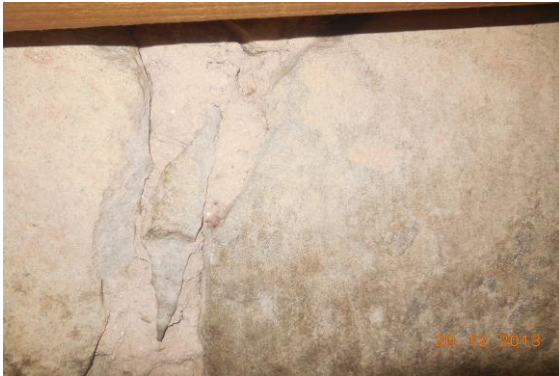
Photo 24
Peeling of Plaster on Wall No. 1 of Shop No. 3 of Ground Floor

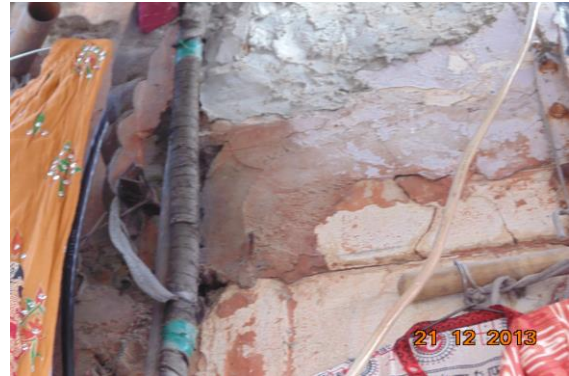
Photo 25
Peeling of Plaster on Wall No. 5 of Keshi international of Ground Floor

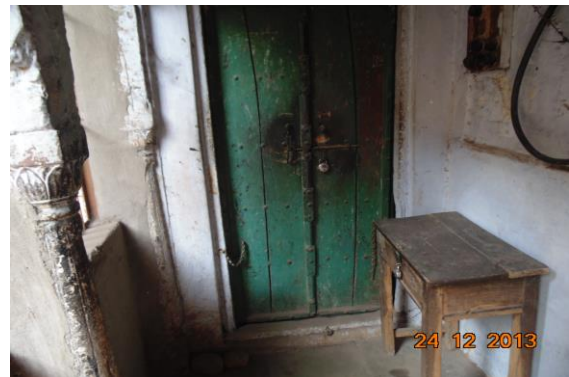
Photo 27
Peeling of Plaster on Wall No. 1 & Main Gate of Shahid Amit Bhardwaj School of Ground Floor

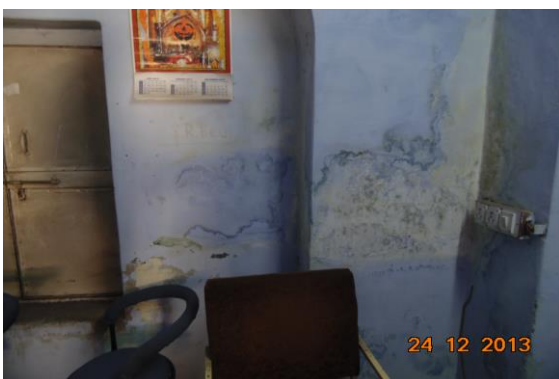
Photo 28
Peeling of Plaster on Outer Wall No.3 of Varanda of Ground Floor

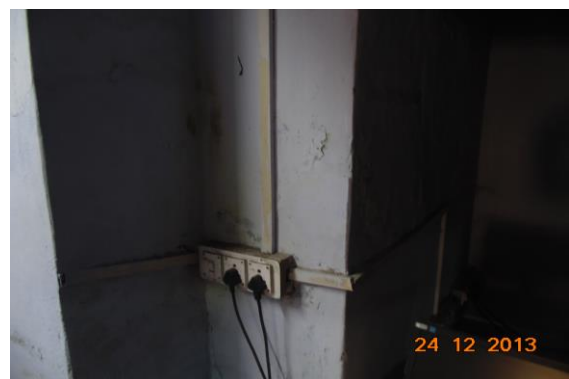
Photo 29
Peeling of Plaster on Wall No. 4 of Varanda of Ground Floor

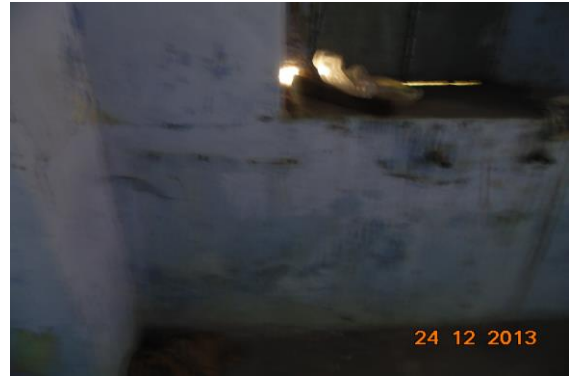
Photo 31

Dampness/Seepage on Wall No. 4 of Hall No. 1 (Part A) of Shahid Amit Bhardwaj School, Ground Floor

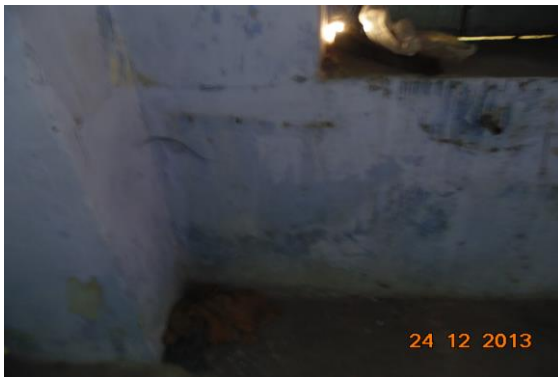
Photo 32

Dampness/Seepage on Wall No. 4 of Hall No. 1 (Part A) of Shahid Amit Bhardwaj School, Ground Floor

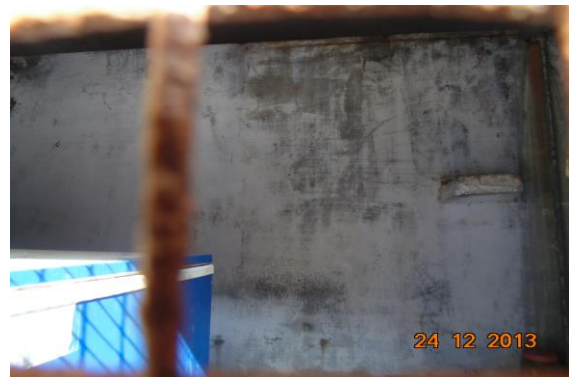
Photo 33

Peeling of Plaster on Roof of Hall No. 1 of Shahid Amit Bhardwaj School, Ground Floor

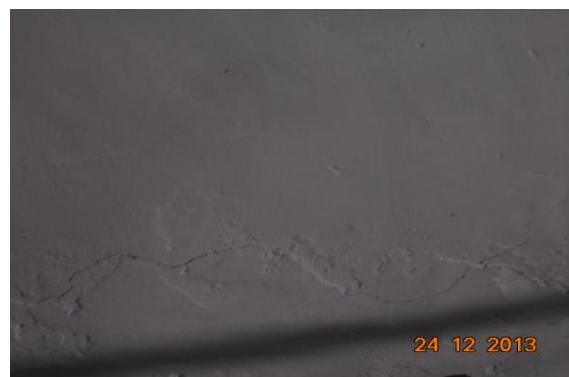
Photo 35

Dampness/Seepage on Wall No. 3 of Hall No. 1 (Part A) of Shahid Amit Bhardwaj School, Ground Floor

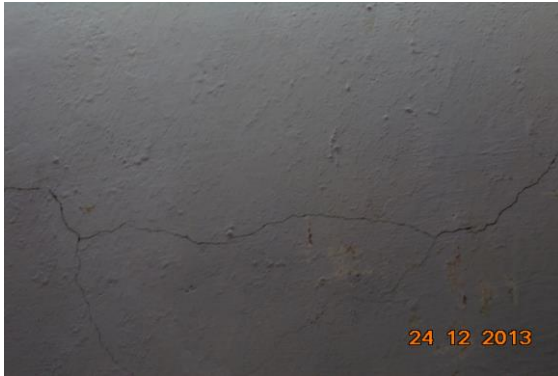
Photo 36

Dampness/Seepage on Roof of Playu of Shahid Amit Bhardwaj School, Ground Floor

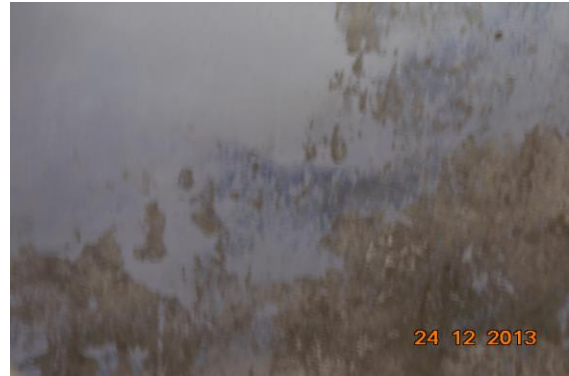
Photo 37

Peeling of Plaster on Roof of Hall No. 3 of Shahid Amit Bhardwaj School, Ground Floor

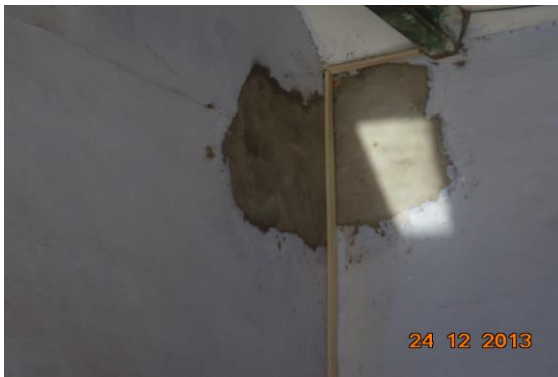
Photo 38

Peeling of Plaster on Roof of Hall No. 3 of Shahid Amit Bhardwaj School, Ground Floor

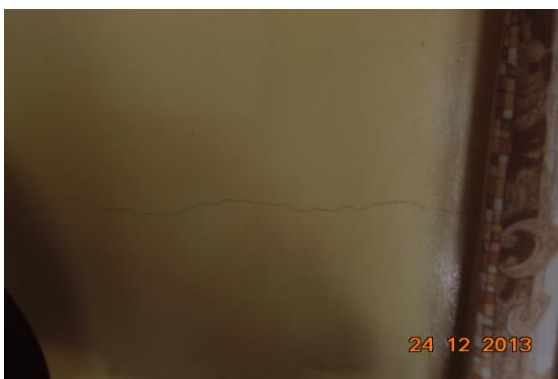
Photo 40

Peeling of Plaster on Wall No. 4 of Hall No. 3 of Shahid Amit Bhardwaj School, Ground Floor

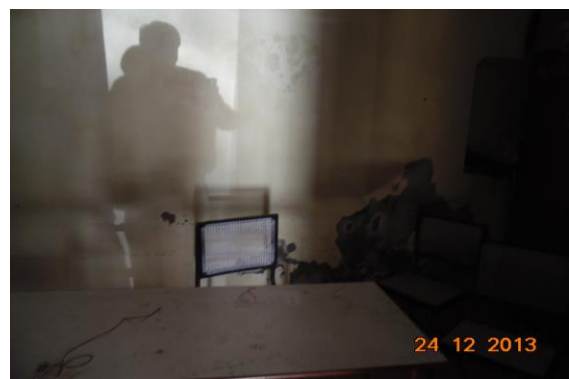
Photo 41

Dampness/Seepage on Wall No. 4 of Hall No. 3 of Shahid Amit Bhardwaj School, Ground Floor

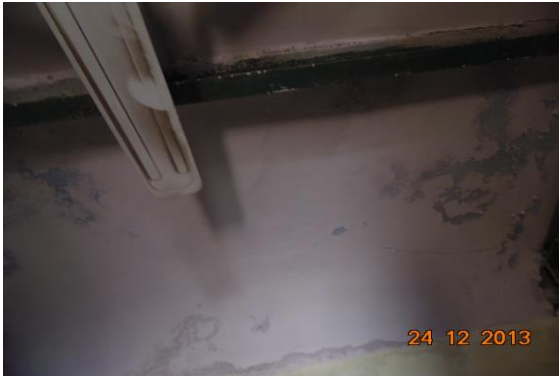
Photo 42

Peeling of Plaster on Wall No. 1 & 4 of Room No. 2 of Shahid Amit Bhardwaj School, Ground Floor

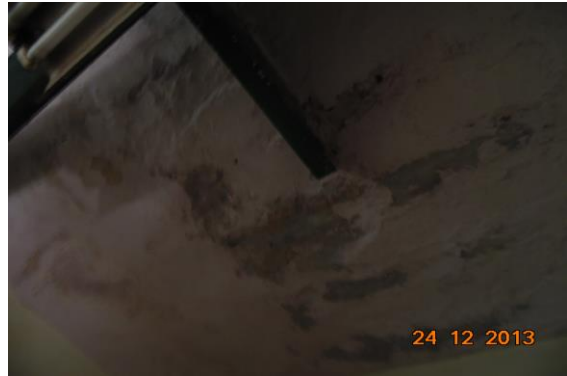
Photo 43

Peeling of Plaster on Wall No. 4 of Room No. 1 (Part A) of Shahid Amit Bhardwaj School, Ground Floor

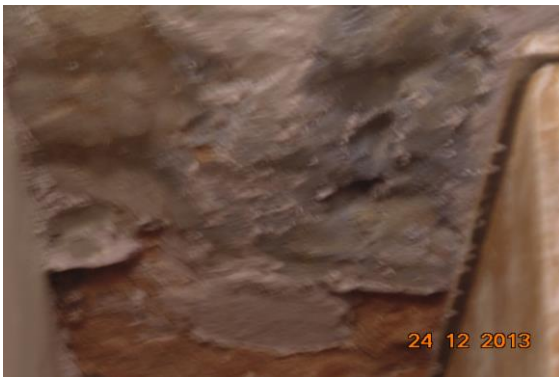
Photo 44

Peeling of Plaster on Wall No. 4 of Room No. 3 of Shahid Amit Bhardwaj School, Ground Floor

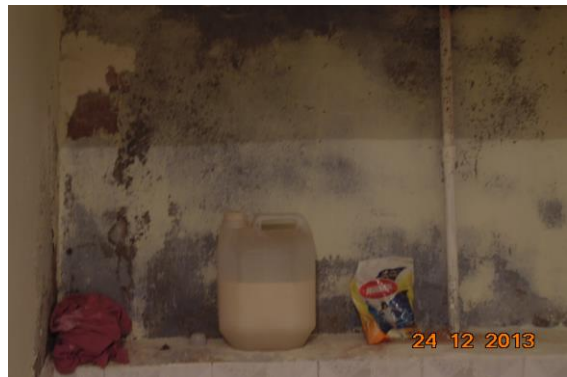
Photo 45

Dampness/Seepage on Wall No. 4 of Room No. 4 of Shahid Amit Bhardwaj School, Ground Floor

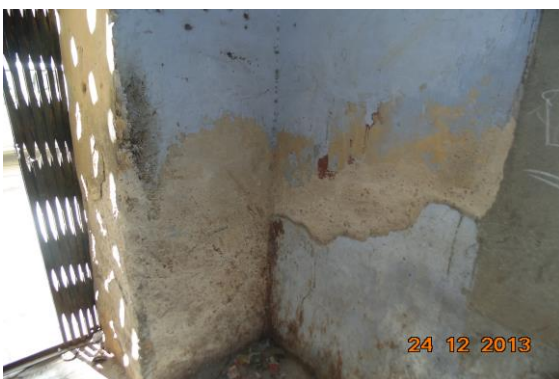
Photo 46

Dampness/Seepage on Roof of Room No. 4 of Shahid Amit Bhardwaj School, Ground Floor

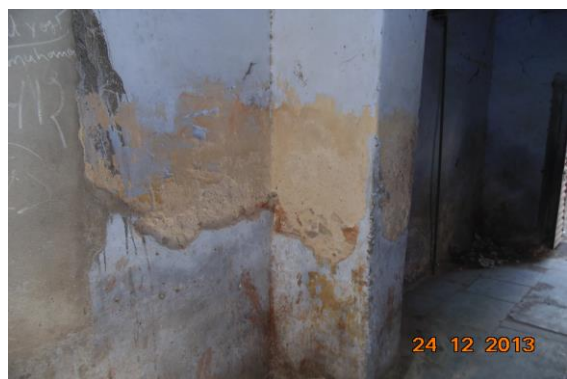
Photo 47

Dampness/Seepage on Roof of Room No. 4 of Shahid Amit Bhardwaj School, Ground Floor

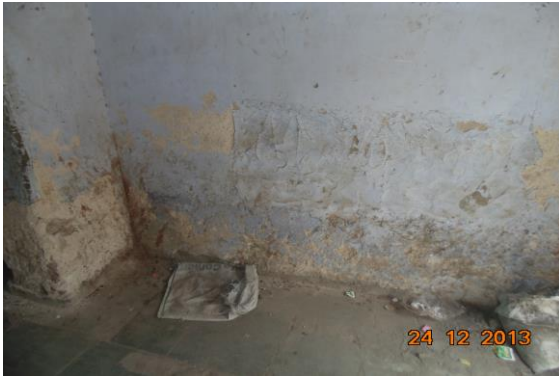
Photo 48

Dampness/Seepage on Roof of Toilet No. 1 of Shahid Amit Bhardwaj School, Ground Floor

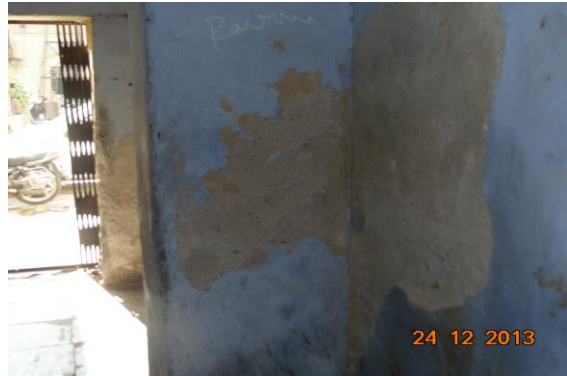
Photo 49

Dampness/Seepage on Wall No. 1 of Toilet No. 1 of Shahid Amit Bhardwaj School, Ground Floor

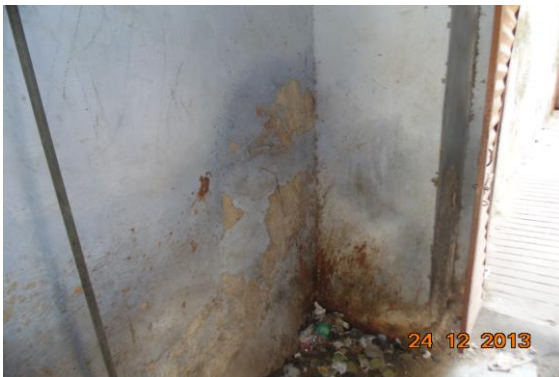
Photo 50

Peeling of Plaster on Wall No. 1 & 3 of Passage No.2 of Shahid Amit Bhardwaj School, Ground Floor

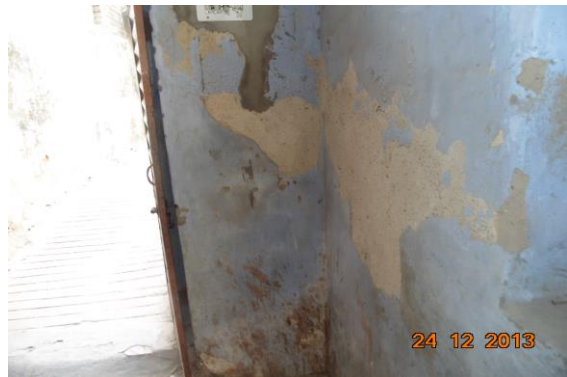
Photo 51

Peeling of Plaster on Wall No. 1 & 4 of Part A of Passage No.2 of Shahid Amit Bhardwaj School, Ground Floor

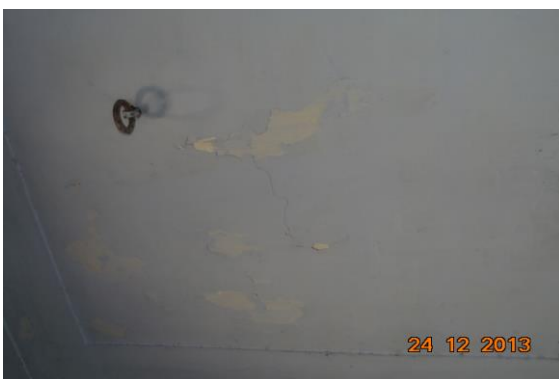
Photo 52

Peeling of Plaster on Wall No. 2 & 4 of Part A of Passage No.2 of Shahid Amit Bhardwaj School, Ground Floor

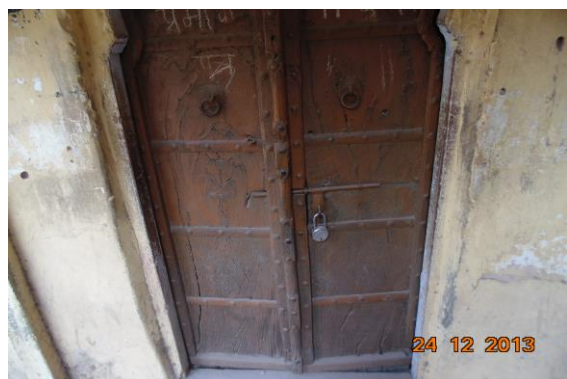
Photo 53

Peeling of Plaster on Wall No. 3 & 1 of Part B of Passage No.2 of Shahid Amit Bhardwaj School, Ground Floor

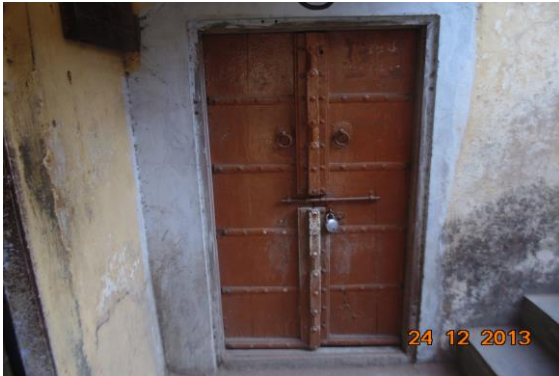
Photo 54

Peeling of Plaster on Wall No. 1 of Part B of Passage No.2 of Shahid Amit Bhardwaj School, Ground Floor

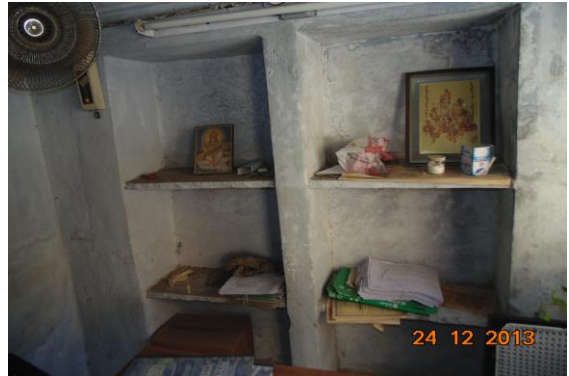
Photo 55

Peeling of Plaster on Wall No. 2 & 4 of Part B of Passage No.2 of Shahid Amit Bhardwaj School, Ground Floor

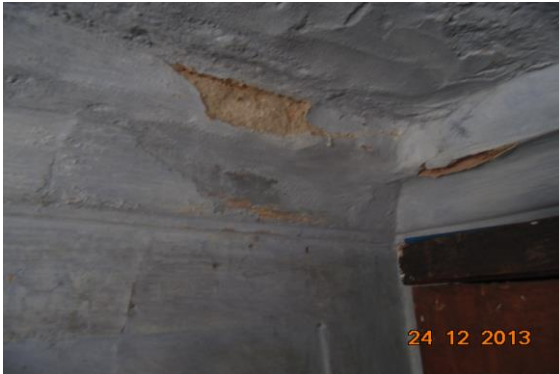
Photo 56

Peeling of Plaster on Roof of Part B of Passage No.2 of Shahid Amit Bhardwaj School, Ground Floor

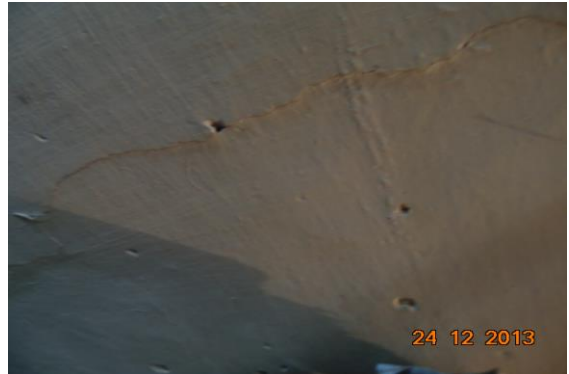
Photo 57

Dampness/Seepage on Wall No. 2 of Room No. 7 of Shahid Amit Bhardwaj School, Ground Floor

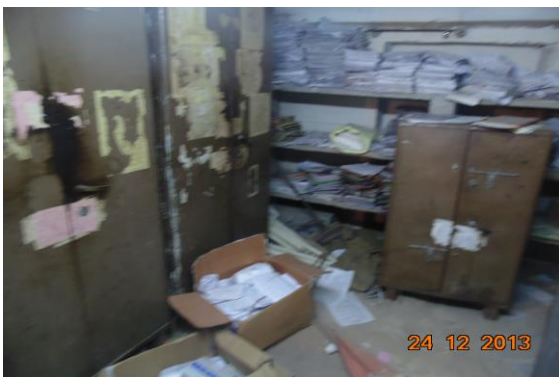
Photo 58

Peeling of Plaster on Wall No. 1 & 4 of Room No. 7 of Shahid Amit Bhardwaj School, Ground Floor

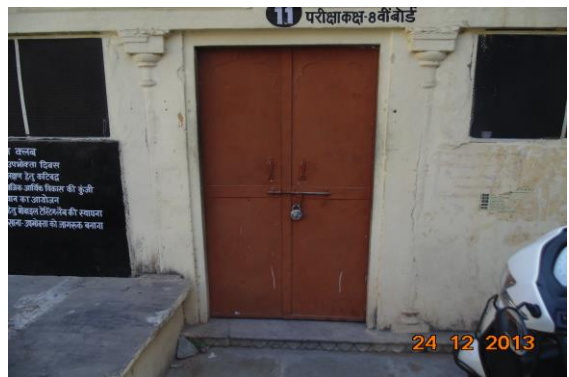
Photo 59

Peeling of Plaster on Wall No. 2 of Room No. 8 of Shahid Amit Bhardwaj School, Ground Floor

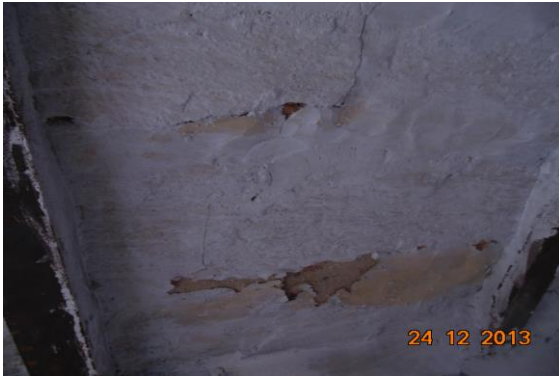
Photo 60

Peeling of Plaster on Wall No. 4 of Room No. 9 of Shahid Amit Bhardwaj School, Ground Floor

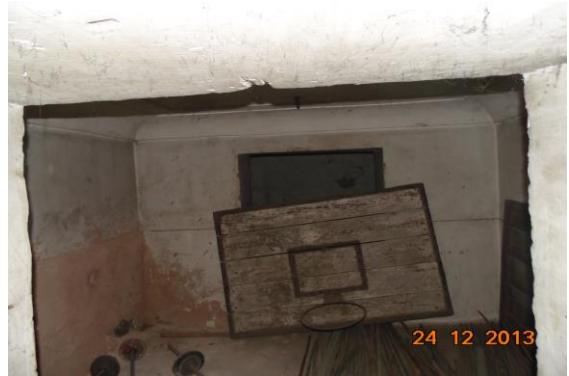
Photo 61

Dampness/Seepage on Roof of Room No. 11 of Shahid Amit Bhardwaj School, Ground Floor

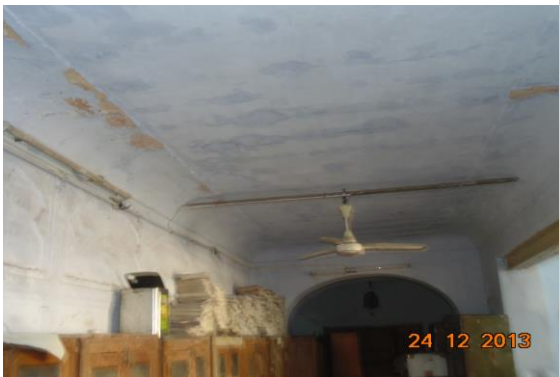
Photo 62

Dampness/Seepage on Wall No. 1 & 3 of Room No. 11 of Shahid Amit Bhardwaj School, Ground Floor

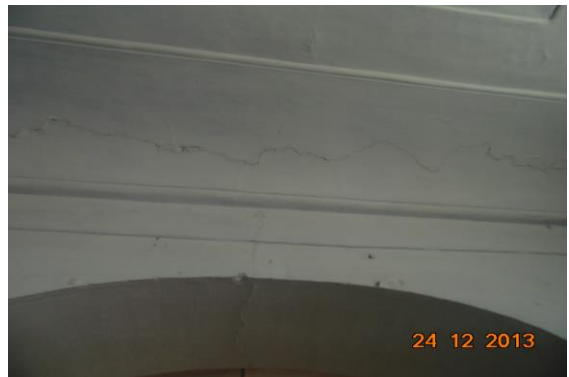
Photo 63

Damaged Portion on Roof of Room No. 11 of Shahid Amit Bhardwaj School, Ground Floor

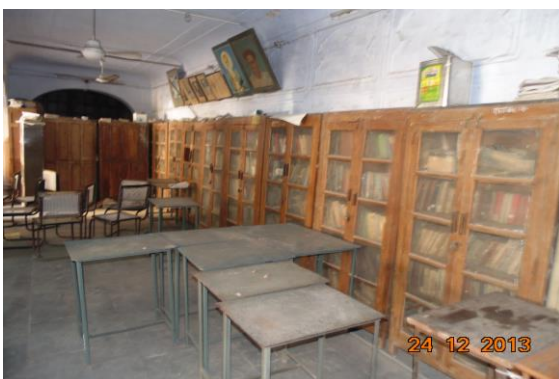
Photo 64

Peeling of Plaster on Wall No. 4 & Roof of Room No. 12 of Shahid Amit Bhardwaj School, Ground Floor

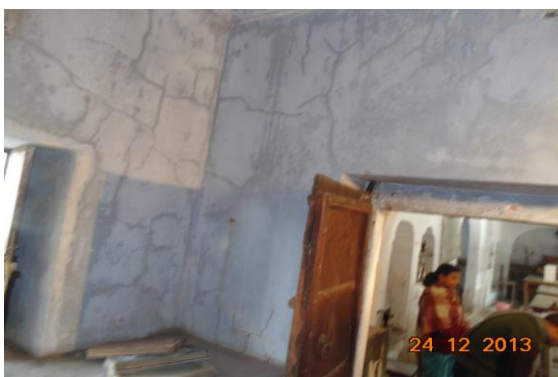
Photo 70

Peeling of Plaster on Wall No. 3 of Hall No. 5 of Ground Floor

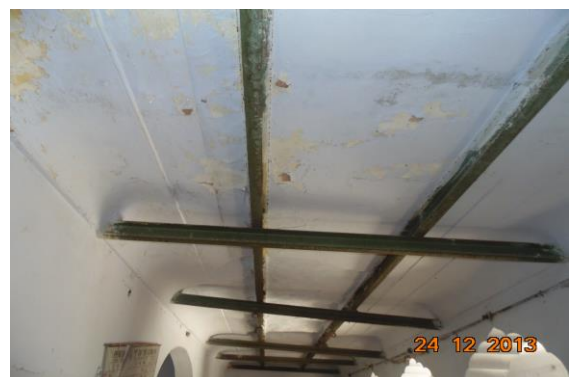
Photo 71

Dampness/Seepage on Roof of Room No. 1 of Shahid Amit Bhardwaj School, First Floor

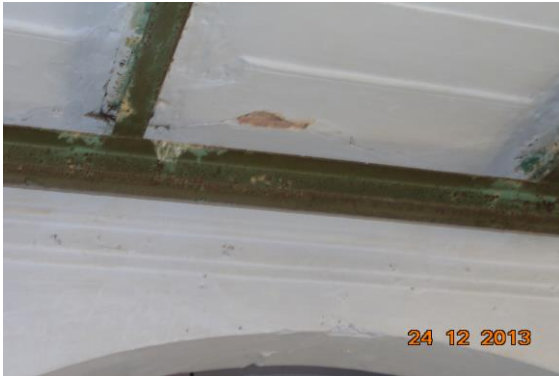
Photo 72

Dampness/Seepage on Wall No. 2 of Room No. 1 of Shahid Amit Bhardwaj School, First Floor

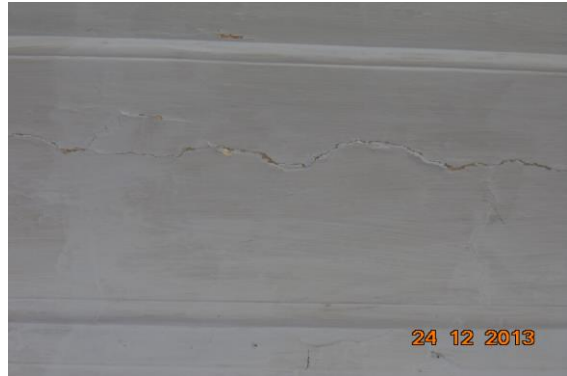
Photo 73

Dampness/Seepage on Wall No. 2 & 3 of Room No. 1 of Shahid Amit Bhardwaj School, First Floor

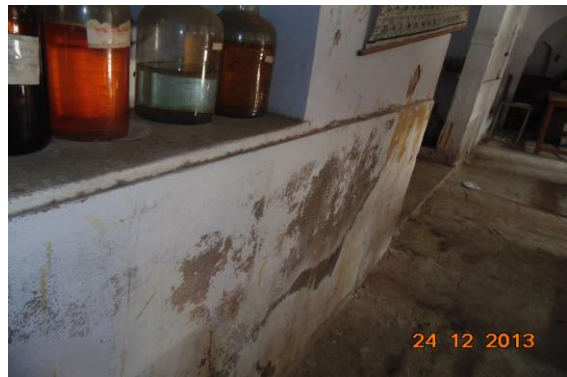
Photo 75

Dampness/Seepage on Roof of Hall No. 1 of Shahid Amit Bhardwaj School, First Floor

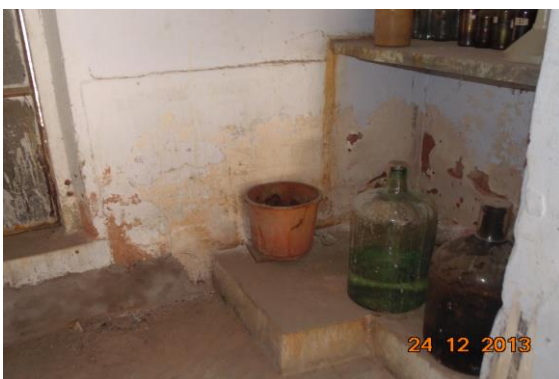
Photo 76

Peeling of Plaster on Roof of Hall No. 1 of Shahid Amit Bhardwaj School, First Floor

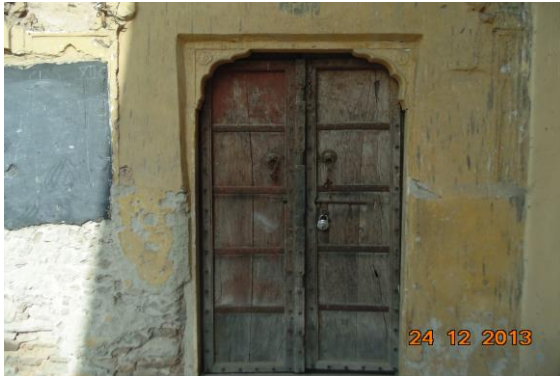
Photo 78

Dampness/Seepage on Wall No. 4 of Hall No. 1 of Shahid Amit Bhardwaj School, First Floor

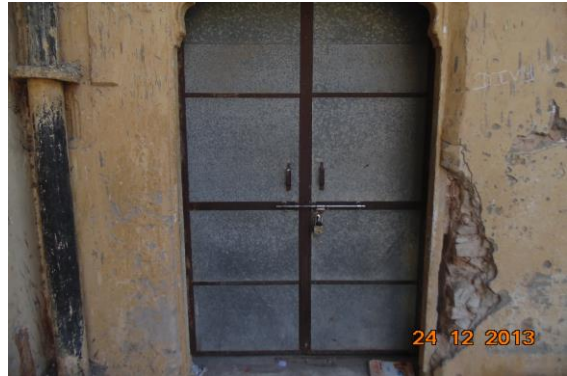
Photo 79

Dampness/Seepage on Wall No. 4 of Hall No. 1 of Shahid Amit Bhardwaj School, First Floor

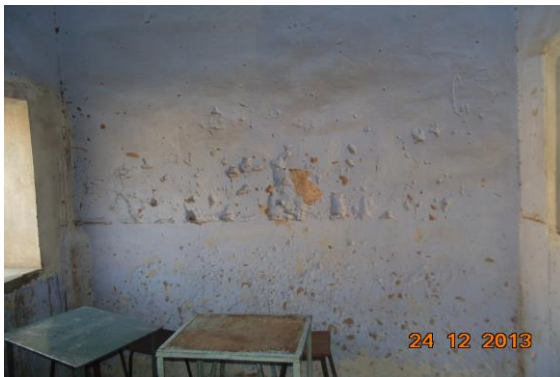
Photo 80

Dampness/Seepage on Wall No. 4 of Hall No. 1 of Shahid Amit Bhardwaj School, First Floor

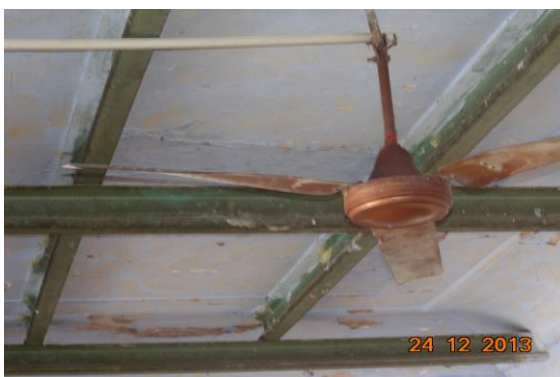
Photo 81

Peeling of Plaster on Wall No. 4 of Room No. 2 of Shahid Amit Bhardwaj School, First Floor

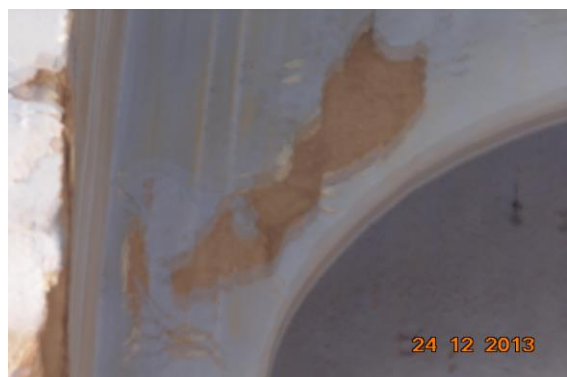
Photo 82

Peeling of Plaster on Wall No. 1 of Hall No. 3 of Shahid Amit Bhardwaj School, First Floor

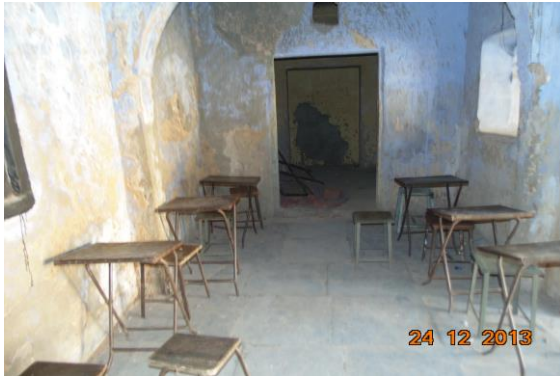
Photo 83

Peeling of Plaster on Wall No. 1 of Hall No. 3 of Shahid Amit Bhardwaj School, First Floor

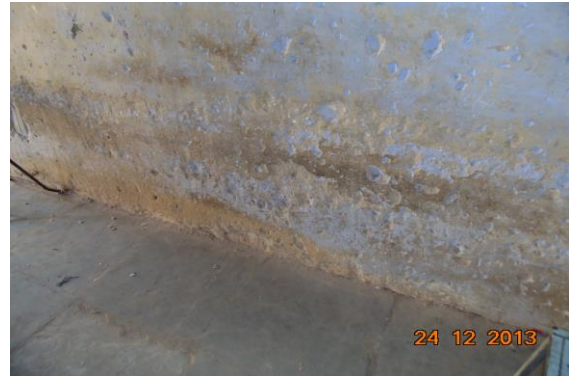
Photo 84

Peeling of Plaster on Wall No. 4 of Hall No. 3 of Shahid Amit Bhardwaj School, First Floor

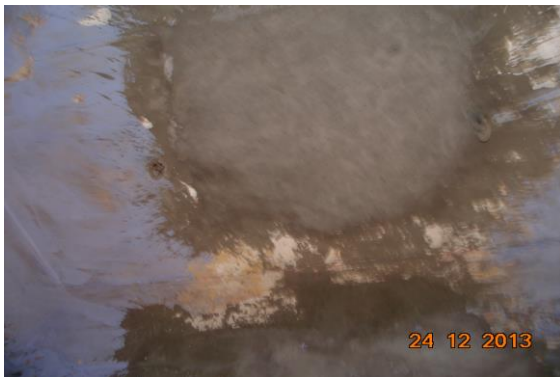
Photo 85

Peeling of Plaster on Wall No. 4 of Hall No. 3 of Shahid Amit Bhardwaj School, First Floor

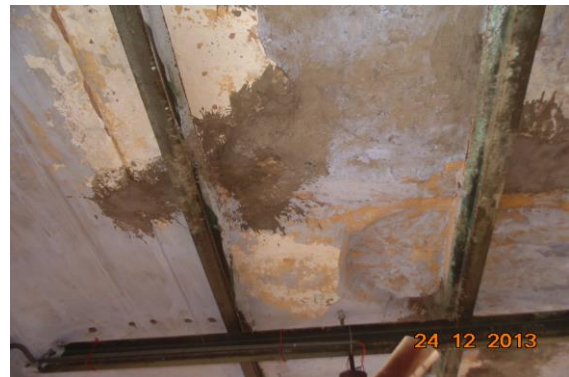
Photo 86

Peeling of Plaster on Roof of Shahid Amit Bhardwaj School of First Floor

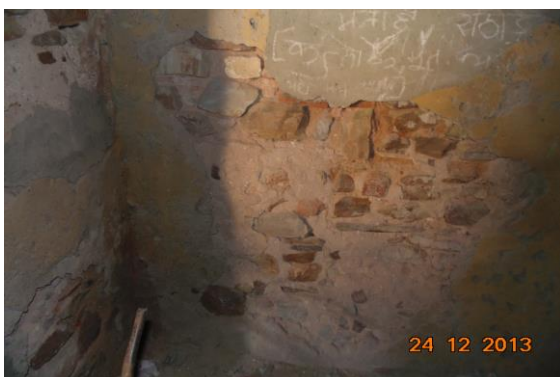
Photo 87

Peeling of Plaster on Roof of Shahid Amit Bhardwaj School of First Floor

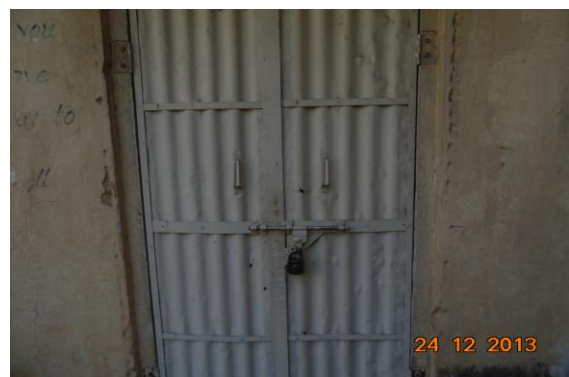
Photo 88

Dampness/Seepage on Wall No. 2, 3 & 4 of Hall No. 4 of Shahid Amit Bhardwaj School, First Floor

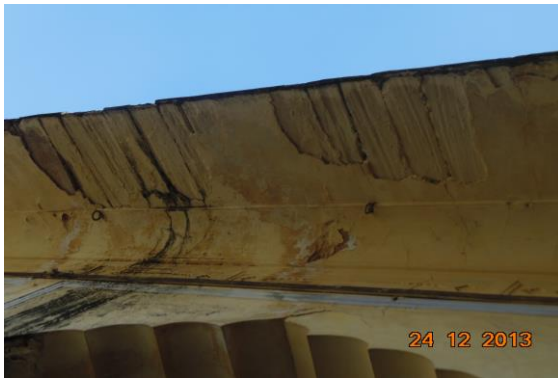
Photo 89

Peeling of Plaster on Wall No. 1 of Hall No. 4 of Shahid Amit Bhardwaj School, First Floor

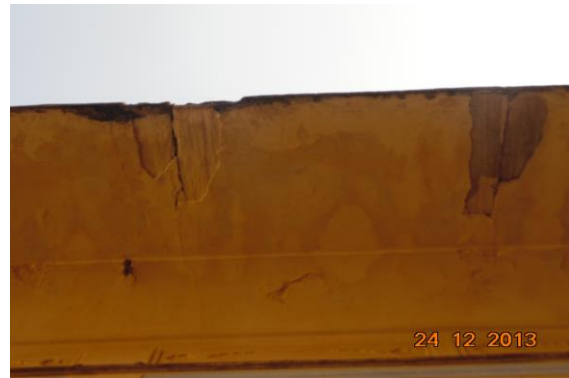
Photo 90

Peeling of Plaster on Roof of Hall No. 4 of Shahid Amit Bhardwaj School, First Floor

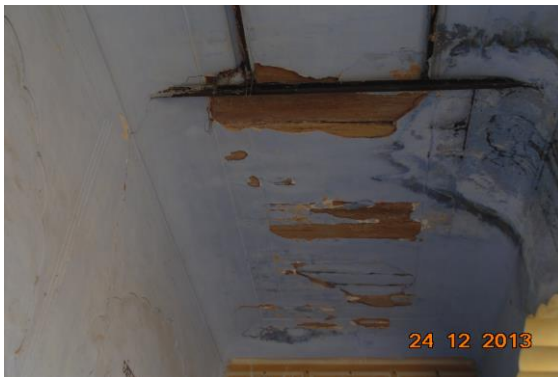
Photo 91

Peeling of Plaster on Roof of Hall No. 4 of Shahid Amit Bhardwaj School, First Floor

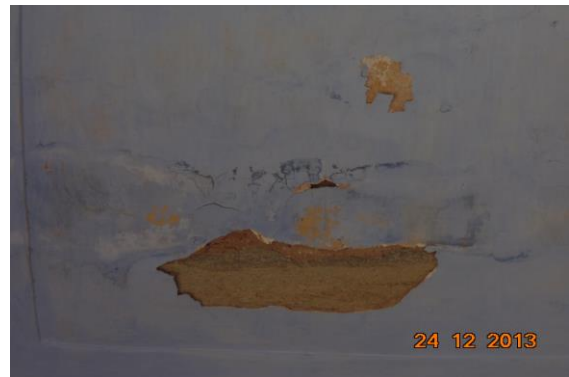
Photo 92

Damaged Portion on Wall No. 1 & 3 of Room No. 4 of Shahid Amit Bhardwaj School, First Floor

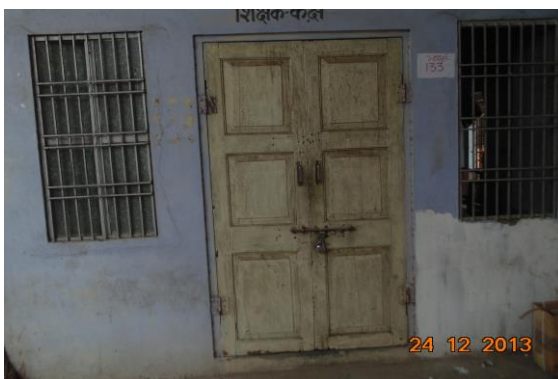
Photo 93

Damaged Portion on Shade & Wall No.3 of Varanda of Shahid Amit Bhardwaj School, First Floor

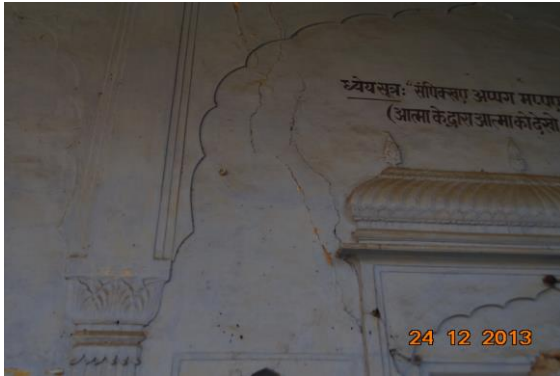
Photo 95

Peeling of Plaster on Roof of Varanda of Shahid Amit Bhardwaj School, First Floor
