Pre Building Condition Survey Report

Name and Address of Structure :	Badi Chopar Station Area
---------------------------------	--------------------------

Name of the Project	Contract JMRC-UG1B “Design and Construction of Tunnel between Chandpole and Badi Chouper and reverse line by Shield TBM, Underground Metro Stations at Choti Chouper and Badi Chouper by Cut and Cover Methods on East West Corridor of Jaipur Metro Rail Corporation Limited .”	
Owner :

Pre - Condition Building Survey for Construction of Underground Stations from Chandpole to Bari Chouper and reversal line

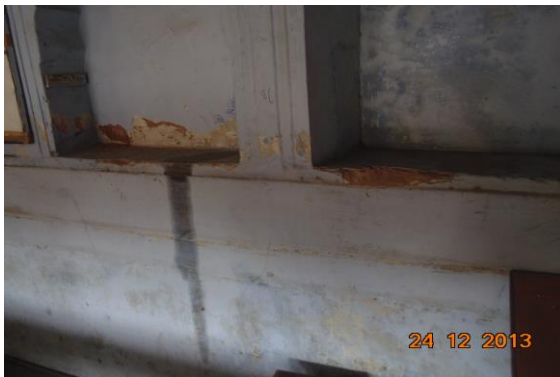
Photo 97

Peeling of Plaster on Roof of Varanda of Shahid Amit Bhardwaj School, First Floor

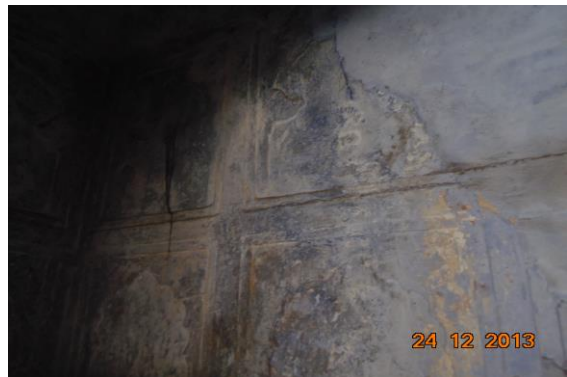
Photo 98

Dampness/Seepage on Roof of Room No. 7 of Shahid Amit Bhardwaj School, First Floor

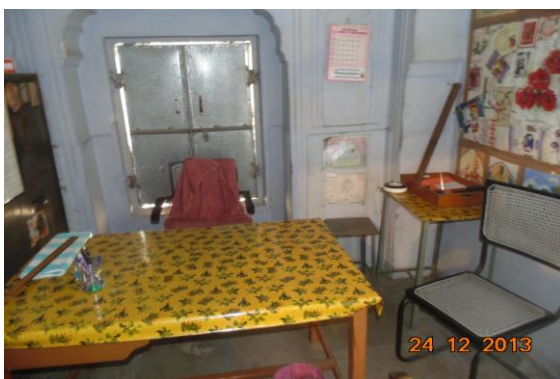
Photo 99

Damaged Portion on Wall No. 1 of Hall No. 5 (Part A) of Shahid Amit Bhardwaj School, First Floor

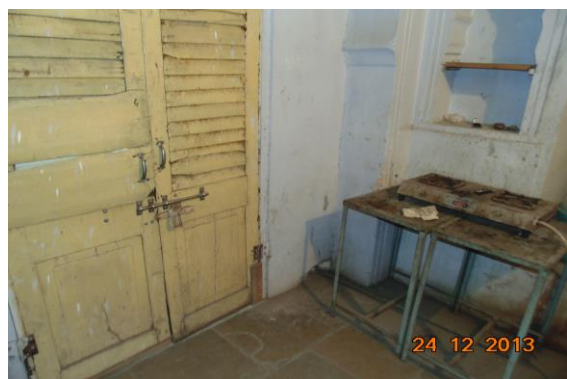
Photo 100

Damaged Portion on Roof of Hall No. 5 (Part A) of Shahid Amit Bhardwaj School, First Floor

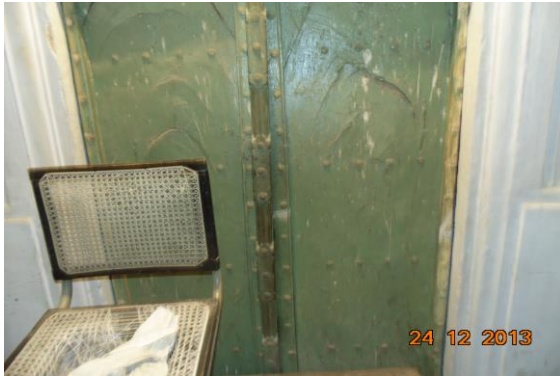
Photo 101

Damaged Portion on Roof of Hall No. 5 (Part A) of Shahid Amit Bhardwaj School, First Floor

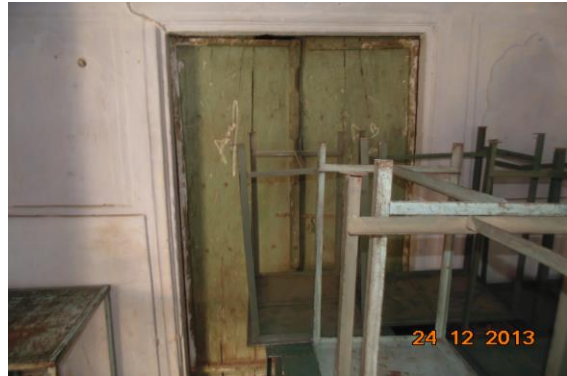
Photo 102

Dampness/Seepage on Wall No. 4 of Hall No. 5 (Part B) of Shahid Amit Bhardwaj School, First Floor

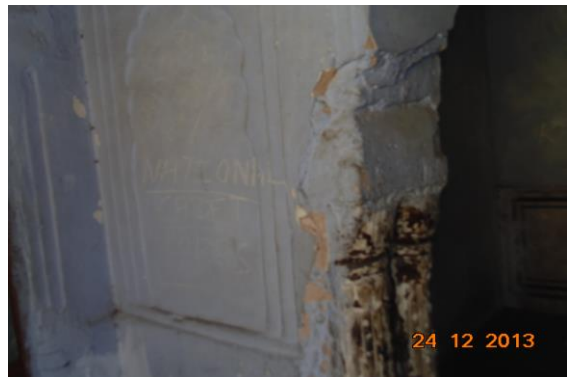
Photo 104

Peeling of Plaster on Roof of Hall No. 6 (Part B) of Shahid Amit Bhardwaj School, First Floor

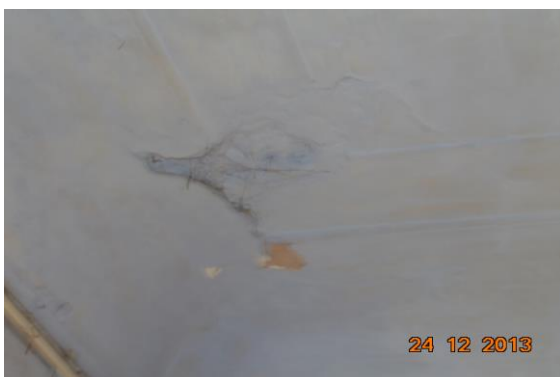
Photo 105

Peeling of Plaster on Roof of Hall No. 7 (Part A) of Shahid Amit Bhardwaj School, First Floor

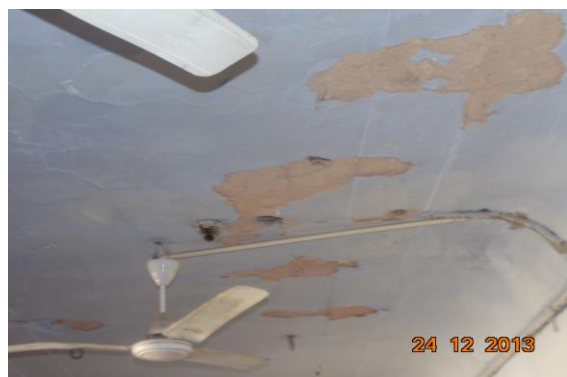
Photo 106

Peeling of Plaster on Roof of Hall No. 7 (Part A) of Shahid Amit Bhardwaj School, First Floor

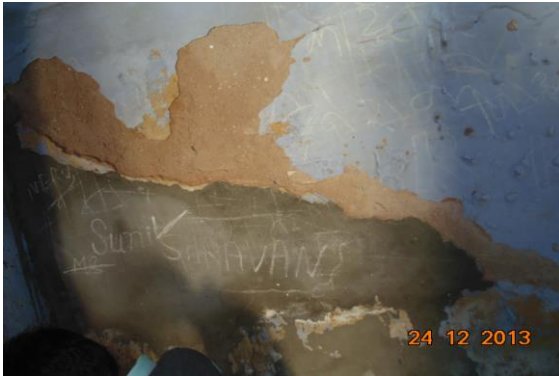
Photo 107

Peeling of Plaster on Wall No. 2 of Hall No. 7 (Part A) of Shahid Amit Bhardwaj School, First Floor

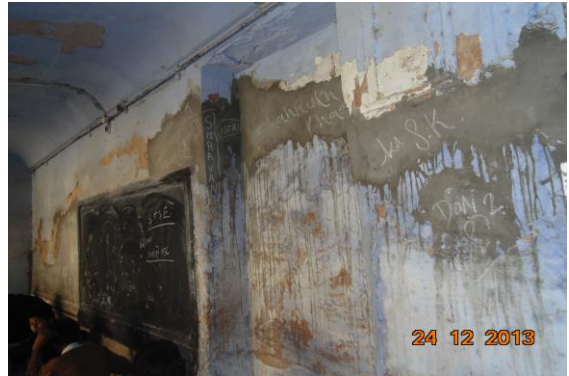
Photo 108

Peeling of Plaster on Wall No. 2 of Hall No. 7 (Part A) of Shahid Amit Bhardwaj School, First Floor

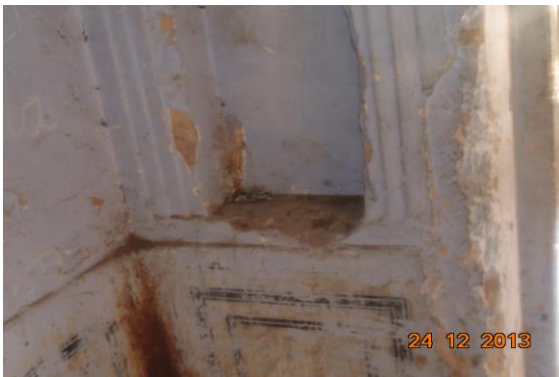
Photo 109

Peeling of Plaster on Wall No. 2 of Hall No. 7 (Part A) of Shahid Amit Bhardwaj School, First Floor

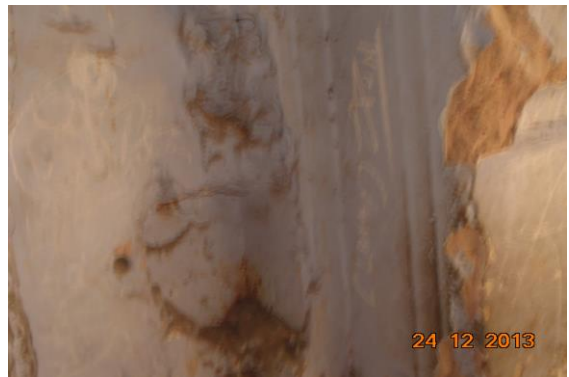
Photo 110

Peeling of Plaster on Roof of Hall No. 7 (Part B) of Shahid Amit Bhardwaj School, First Floor

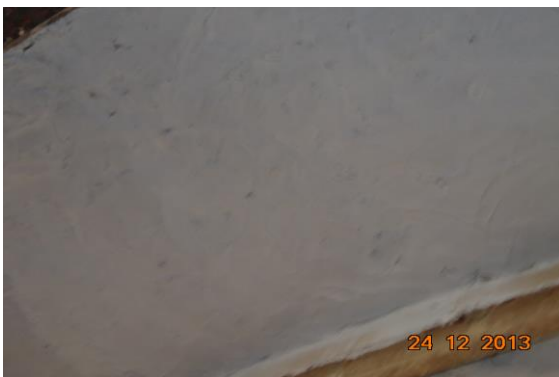
Photo 111

Peeling of Plaster on Roof of Hall No. 7 (Part B) of Shahid Amit Bhardwaj School, First Floor

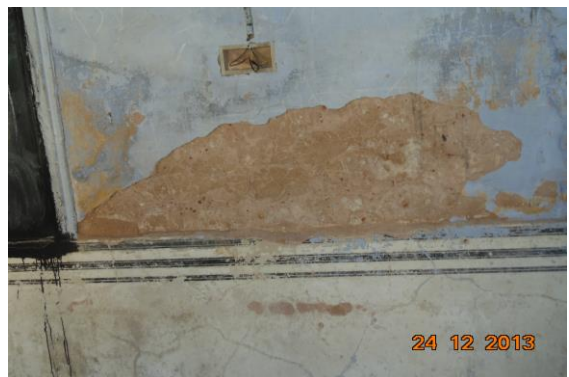
Photo 112

Peeling of Plaster on Wall No. 4 of Hall No. 7 (Part B) of Shahid Amit Bhardwaj School, First Floor

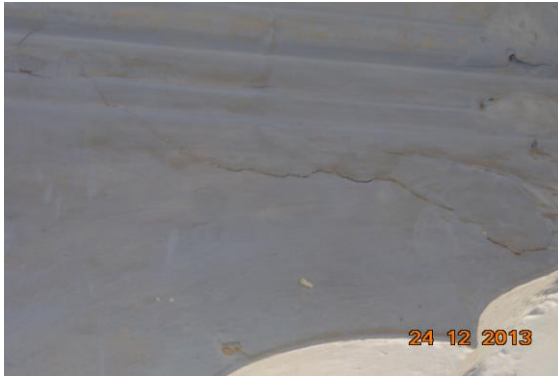
Photo 113

Peeling of Plaster on Wall No. 4 of Hall No. 7 (Part B) of Shahid Amit Bhardwaj School, First Floor

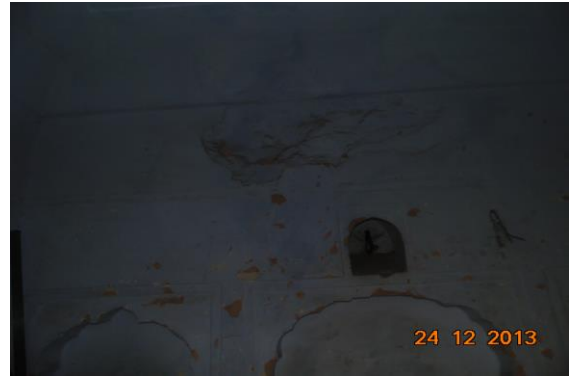
Photo 114

Peeling of Plaster on Wall No. 3 of Hall No. 7 (Part B) of Shahid Amit Bhardwaj School, First Floor

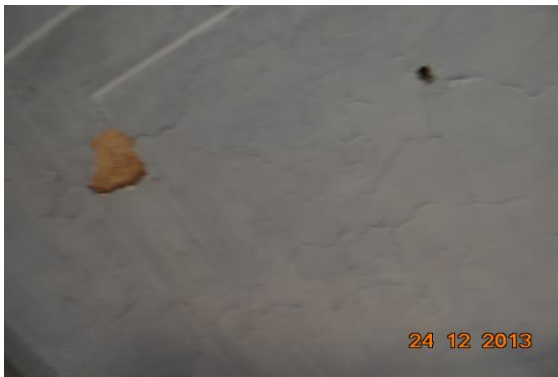
Photo 115

Peeling of Plaster on Wall No. 3 of Hall No. 7 (Part B) of Shahid Amit Bhardwaj School, First Floor

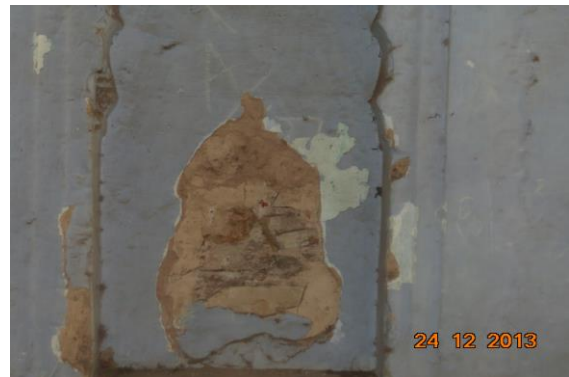
Photo 116

Peeling of Plaster on Roof of Hall No. 7 (Part B) of Shahid Amit Bhardwaj School, First Floor

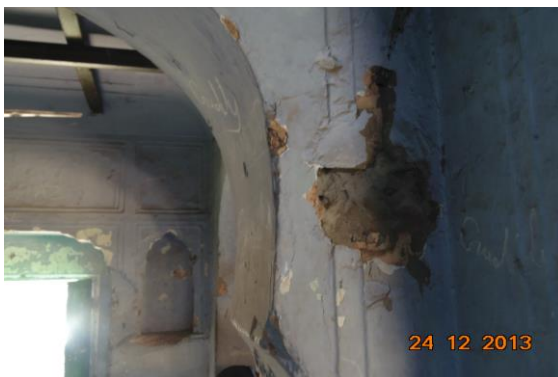
Photo 117

Peeling of Plaster on Wall No. 4 of Hall No. 7 (Part B) of Shahid Amit Bhardwaj School, First Floor

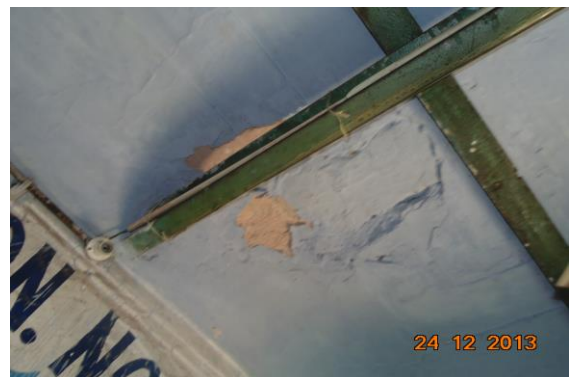
Photo 118

Peeling of Plaster on Wall No. 3 of Hall No. 7 (Part B) of Shahid Amit Bhardwaj School, First Floor

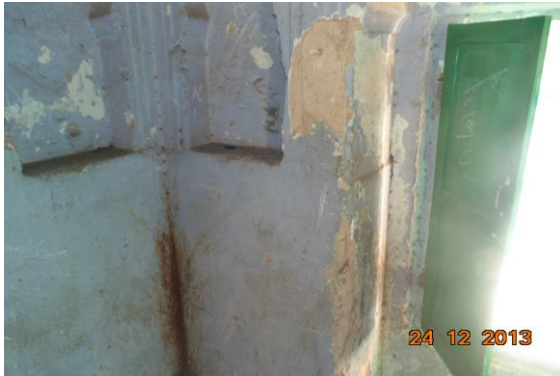
Photo 119

Peeling of Plaster on Wall No. 4 of Room No. 13 of Shahid Amit Bhardwaj School, First Floor

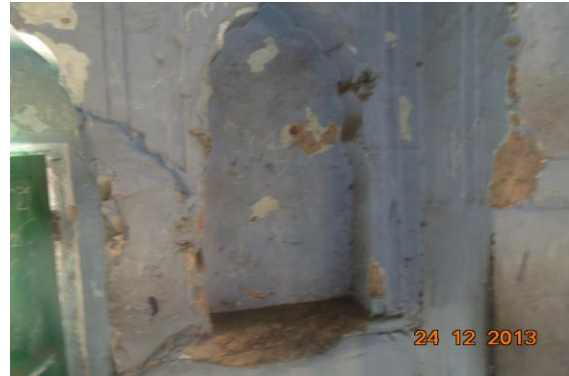
Photo 121
Peeling of Plaster on Wall No. 1 of Hall No. 8 (Part A) of Shahid Amit Bhardwaj School, First Floor

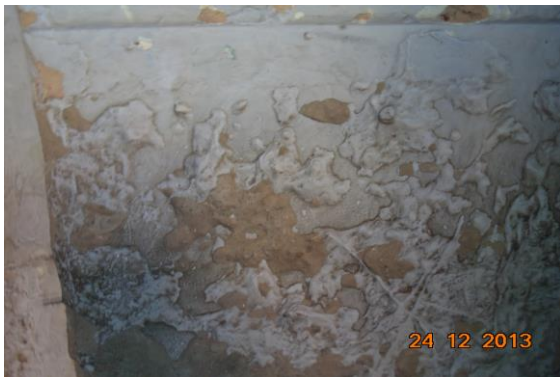
Photo 122
Peeling of Plaster on Wall No. 4 of Hall No. 8 (Part A) of Shahid Amit Bhardwaj School, First Floor

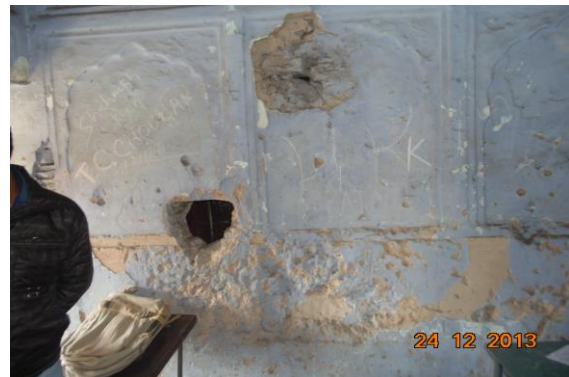
Photo 123
Peeling of Plaster on Roof of Hall No. 8 (Part B) of Shahid Amit Bhardwaj School, First Floor

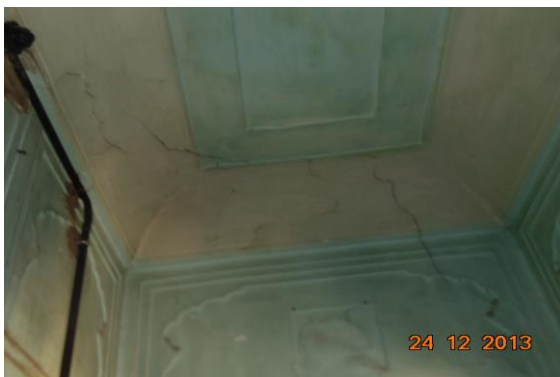
Photo 124
Peeling of Plaster on Wall No. 4 of Hall No. 8 (Part B) of Shahid Amit Bhardwaj School, First Floor

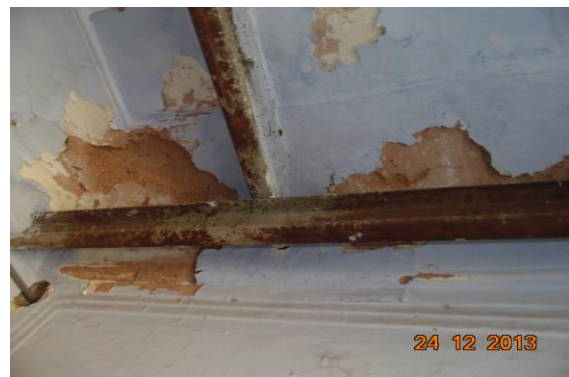
Photo 125
Peeling of Plaster on Wall No. 4 of Hall No. 8 (Part B) of Shahid Amit Bhardwaj School, First Floor

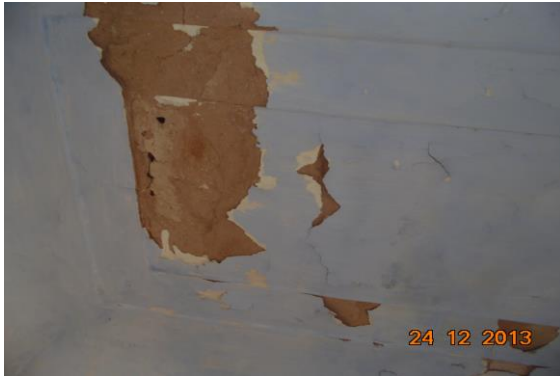
Photo 126

Peeling of Plaster on Wall No. 3 of Hall No. 8 (Part B) of Shahid Amit Bhardwaj School, First Floor

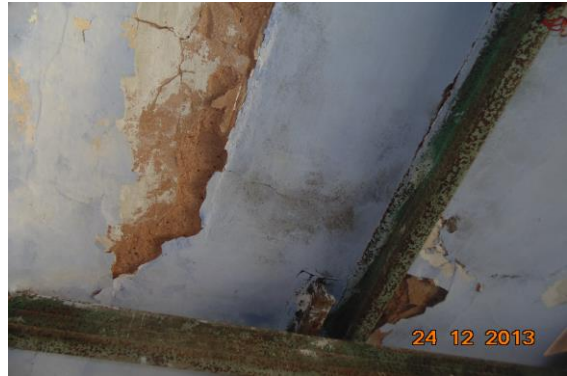
Photo 127

Peeling of Plaster on Wall No. 2 of Hall No. 8 (Part B) of Shahid Amit Bhardwaj School, First Floor

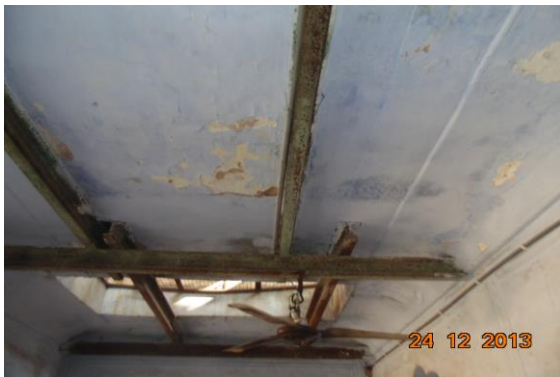
Photo 128

Damaged Portion on Roof & Wall No. 1 of Hall Store No.2 of Shahid Amit Bhardwaj School, First Floor

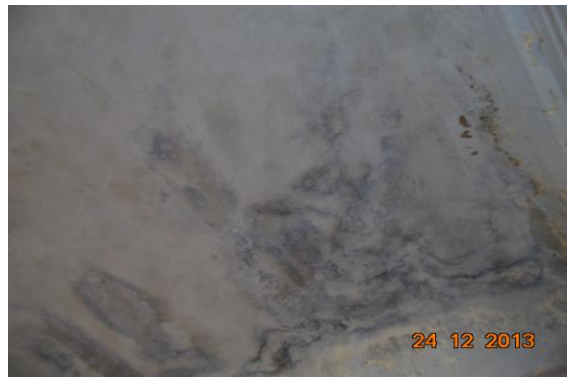
Photo 129

Dampness/Seepage on Roof of Hall No. 2 (Part A) of Shahid Amit Bhardwaj School, Second Floor

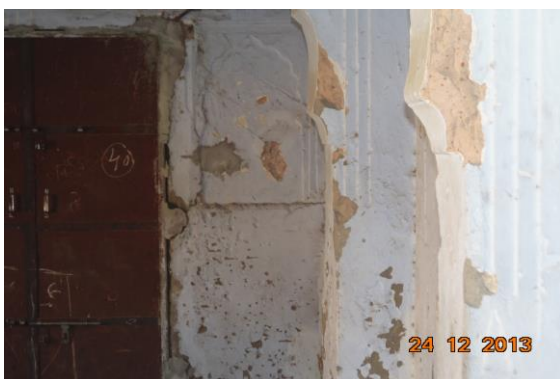
Photo 130

Dampness/Seepage on Roof of Hall No. 2 (Part A) of Shahid Amit Bhardwaj School, Second Floor

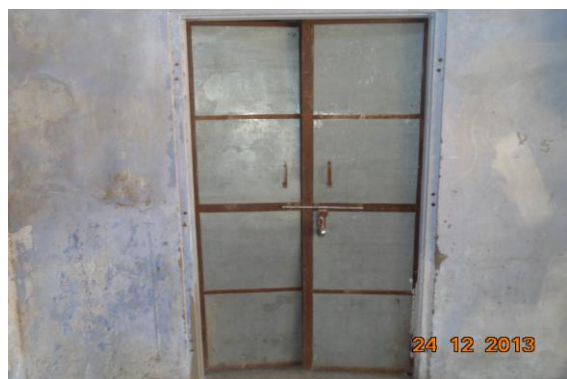
Photo 131

Peeling of Plaster on Wall No. 1 & 4 of Shahid Amit Bhardwaj School of Second Floor

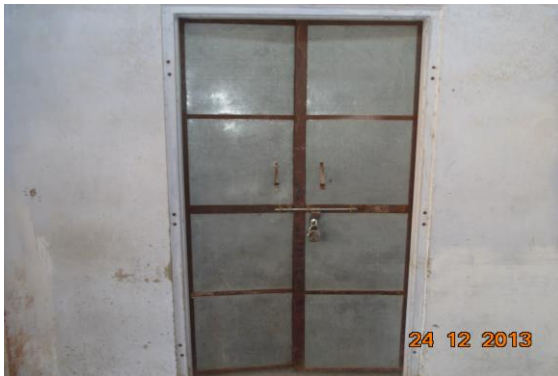
Photo 132

Peeling of Plaster on Wall No. 1 & 4 of Shahid Amit Bhardwaj School of Second Floor

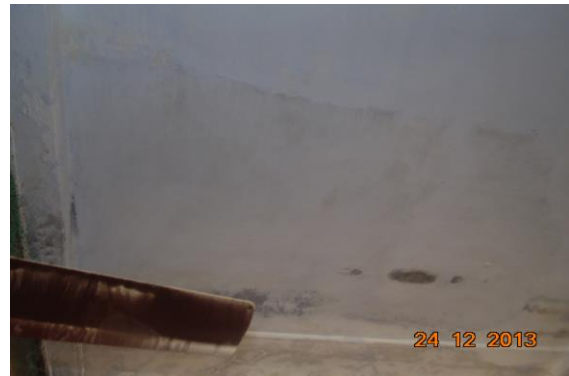
Photo 133

Peeling of Plaster on Wall No. 1 & 4 of Shahid Amit Bhardwaj School of Second Floor

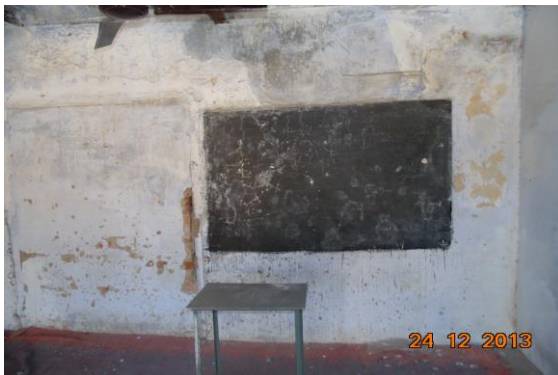
Photo 134

Peeling of Plaster on Wall No. 1 & 4 of Room No. 2 (Part B) of Shahid Amit Bhardwaj School, Second Floor

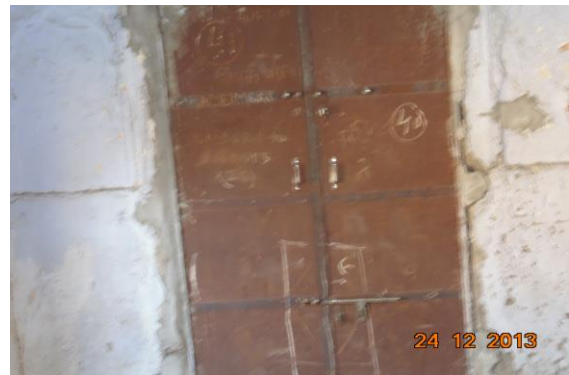
Photo 135

Dampness/Seepage on Roof of Hall No. 2 (Part B) of Shahid Amit Bhardwaj School, Second Floor

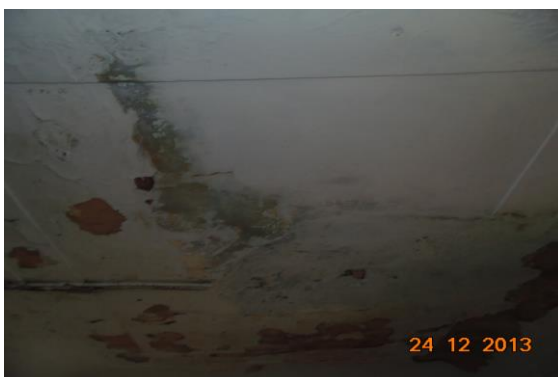
Photo 136

Peeling of Plaster on Wall No. 4 of Hall No. 2 (Part B) of Shahid Amit Bhardwaj School, Second Floor

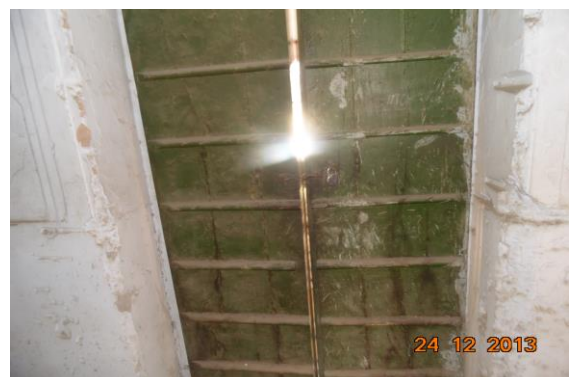
Photo 137

Peeling of Plaster on Wall No. 4 of Hall No. 2 (Part B) of Shahid Amit Bhardwaj School, Second Floor

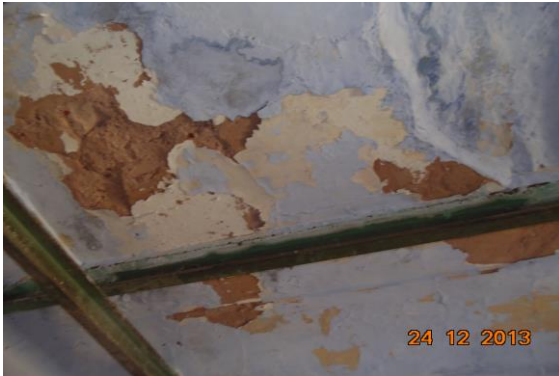
Photo 138

Peeling of Plaster on Wall No. 4 of Hall No. 2 (Part B) of Shahid Amit Bhardwaj School, Second Floor

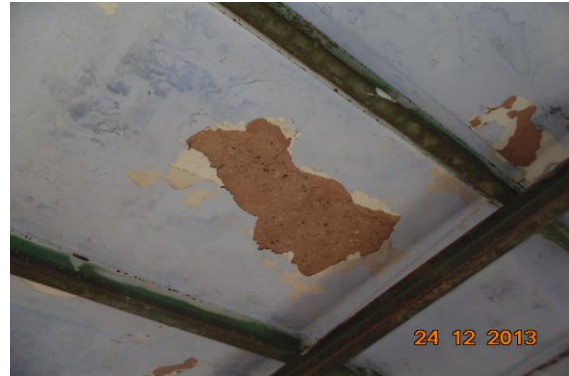
Photo 139

Dampness/Seepage on Roof of Lobby of Second Floor

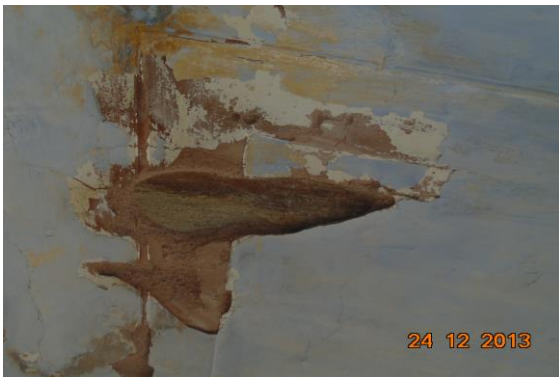
Photo 140

Dampness/Seepage on Roof of Room No. 3 of Shahid Amit Bhardwaj School, Second Floor

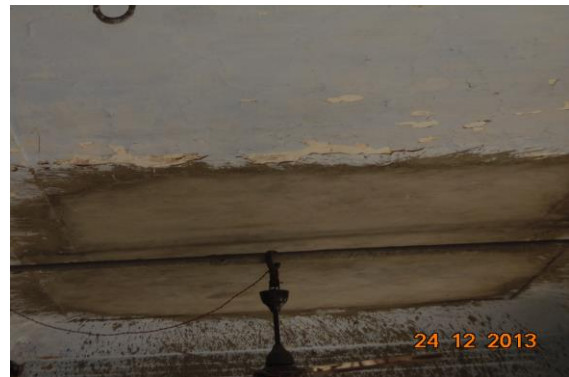
Photo 141

Dampness/Seepage on Roof of Room No. 3 of Shahid Amit Bhardwaj School, Second Floor

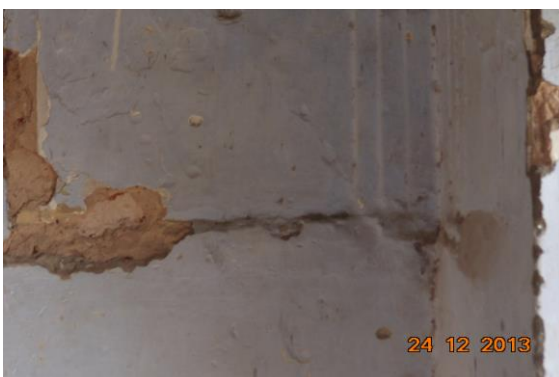
Photo 142

Dampness/Seepage on Roof of Room No. 3 of Shahid Amit Bhardwaj School, Second Floor

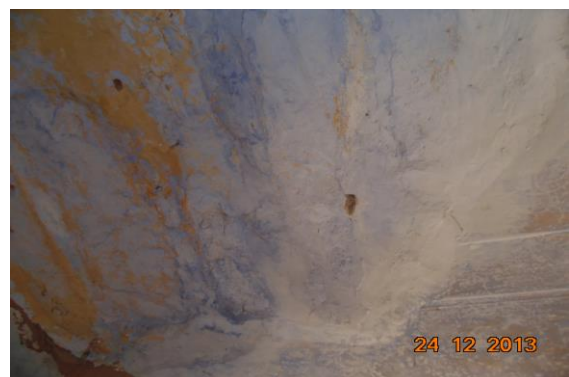
Photo 143

Dampness/Seepage on Roof of Hall No. 3 (Part A) of Shahid Amit Bhardwaj School, Second Floor

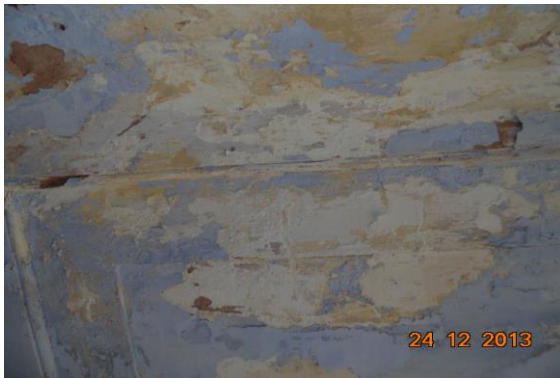
Photo 144

Dampness/Seepage on Roof of Hall No. 3 (Part A) of Shahid Amit Bhardwaj School, Second Floor

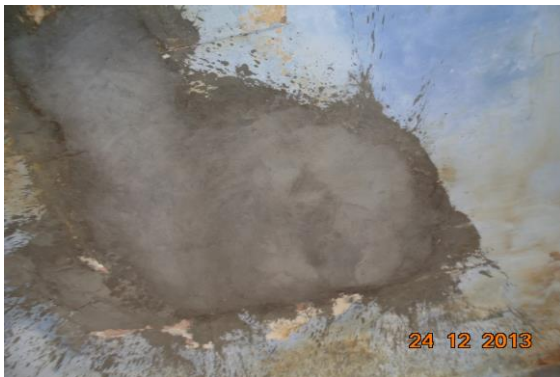
Photo 146

Peeling of Plaster on Wall No. 2 & 4 of Hall No. 3 (Part A) of Shahid Amit Bhardwaj School, Second Floor

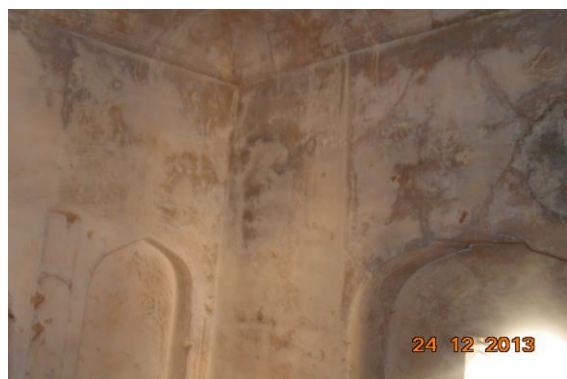
Photo 149

Peeling of Plaster on Roof of Hall No. 3 (Part B) of Shahid Amit Bhardwaj School, Second Floor

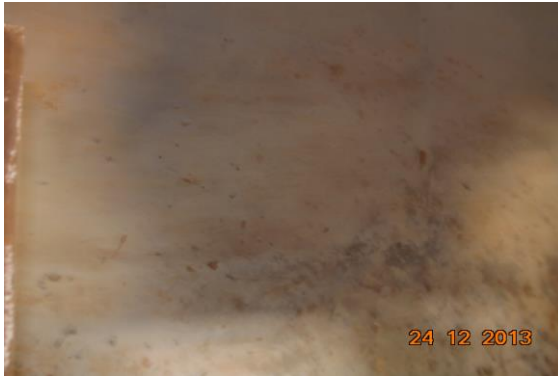
Photo 150

Peeling of Plaster on Roof of Hall No. 3 (Part B) of Shahid Amit Bhardwaj School, Second Floor

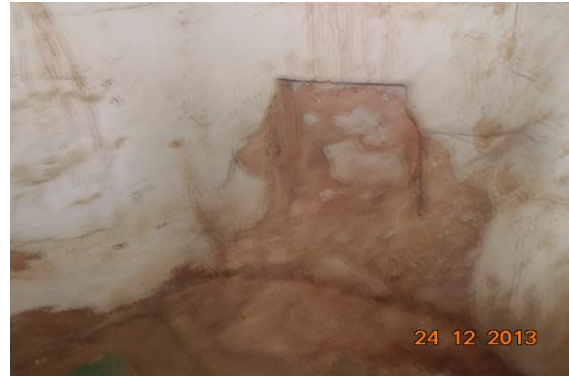
Photo 151

Peeling of Plaster on Wall No. 4 of Hall No. 3 (Part B) of Shahid Amit Bhardwaj School, Second Floor

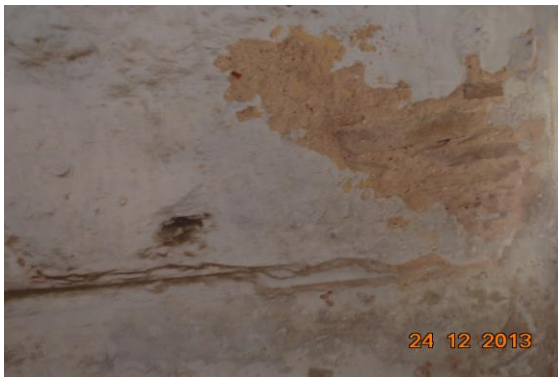
Photo 152

Dampness/Seepage on Roof of Room No. 4 of Shahid Amit Bhardwaj School, Second Floor

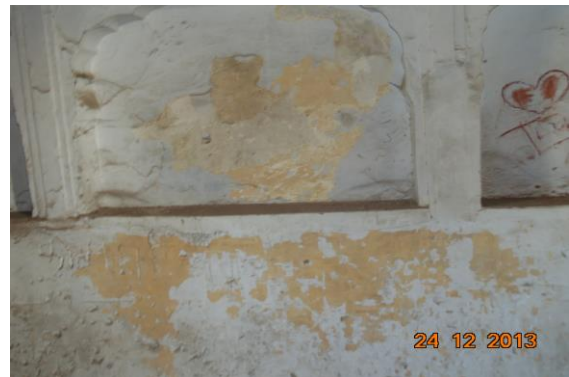
Photo 153

Dampness/Seepage on Wall No. 2 & 4 of Room No. 4 of Shahid Amit Bhardwaj School, Second Floor

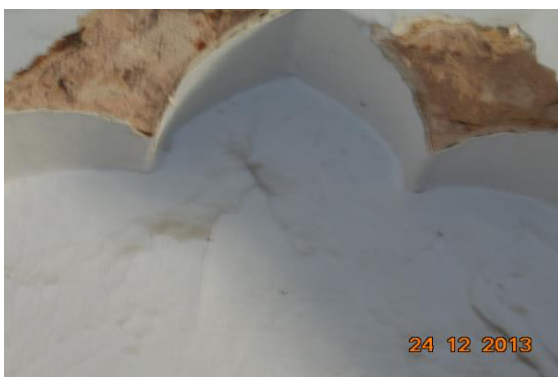
Photo 154

Dampness/Seepage on Wall No. 1 of Room No. 4 of Shahid Amit Bhardwaj School, Second Floor

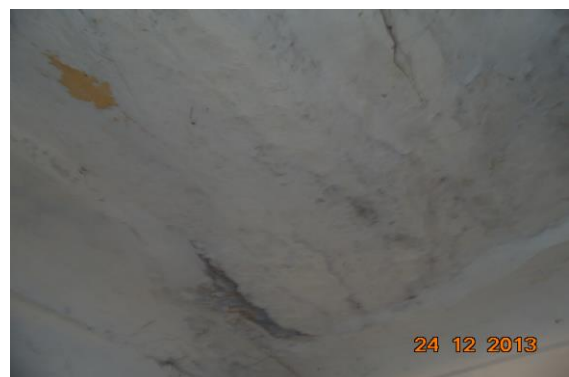
Photo 155

Dampness/Seepage on Wall No. 4 of Tomb No.1 of Second Floor

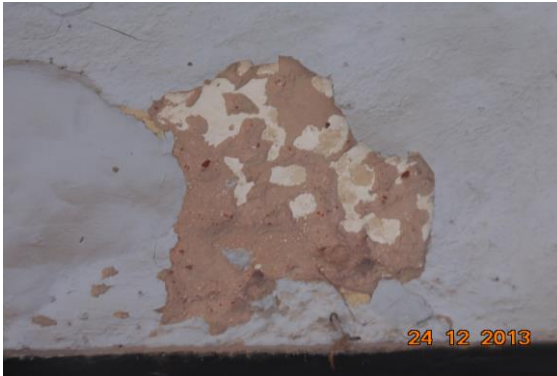
Photo 156

Peeling of Plaster on Wall No. 3 of Lobby No.3 of Second Floor

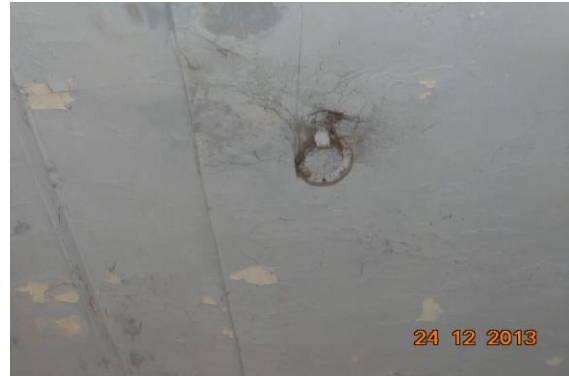
Photo 157

Peeling of Plaster on Wall No. 3 of Lobby No.3 of Second Floor

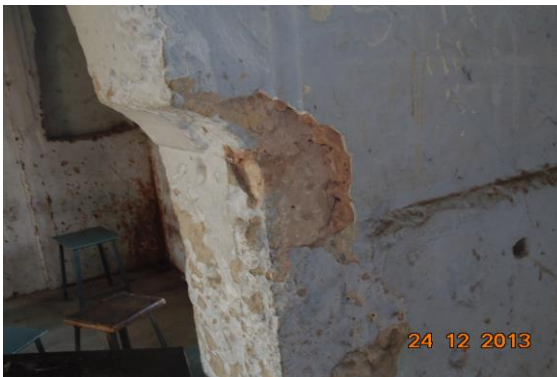
Photo 158

Peeling of Plaster on Wall No. 4 of Lobby No.3 of Second Floor

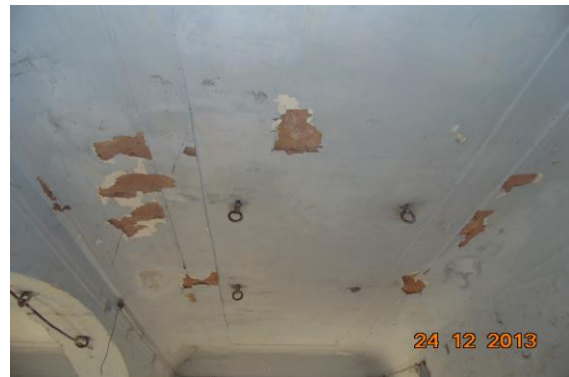
Photo 159

Dampness/Seepage on Wall No. 4 of Lobby No.3 of Second Floor

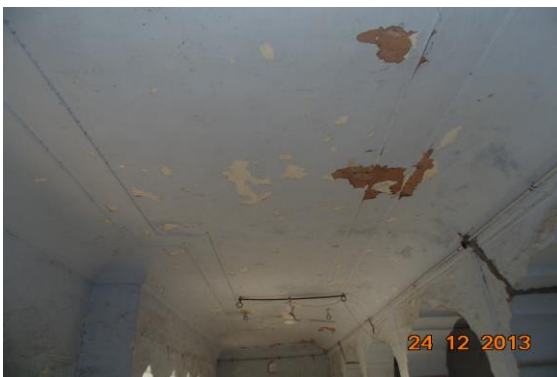
Photo 160

Peeling of Plaster on Wall No. 3 of Room No. 5 (Part A) of Shahid Amit Bhardwaj School, Second Floor

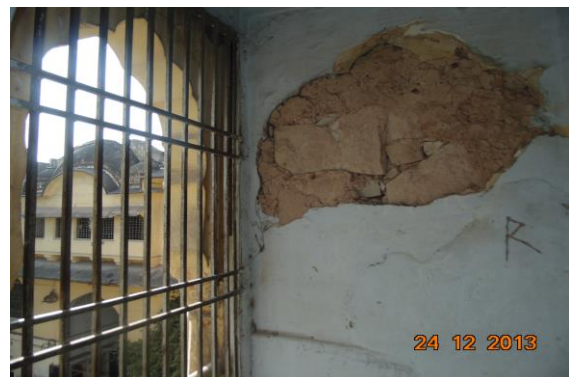
Photo 161

Dampness/Seepage on Roof of Room No. 5 (Part A) of Shahid Amit Bhardwaj School, Second Floor

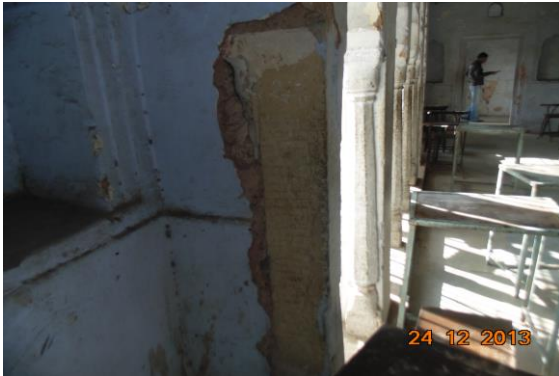
Photo 162

Peeling of Plaster on Wall No. 4 of Room No. 5 (Part A) of Shahid Amit Bhardwaj School, Second Floor

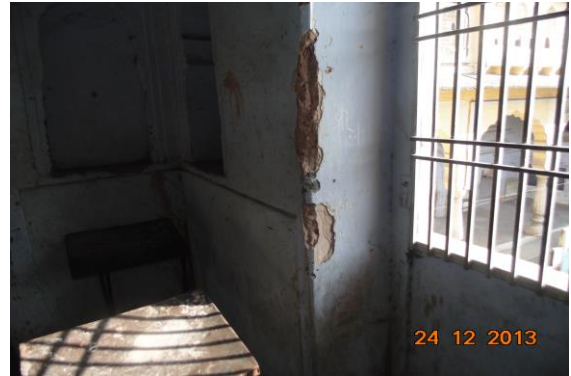
Photo 163

Peeling of Plaster on Roof of Room No. 5 (Part B) of Shahid Amit Bhardwaj School, Second Floor

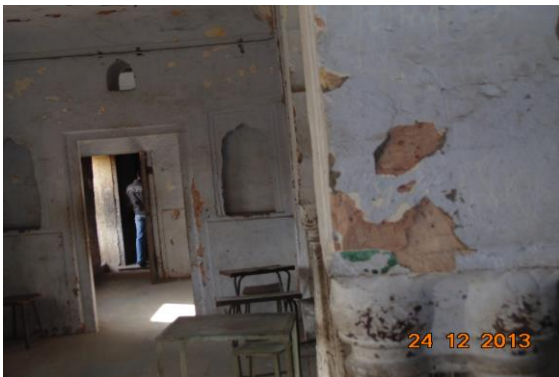
Photo 164

Dampness/Seepage on Roof of Hall No. 4 (Part A) of Shahid Amit Bhardwaj School, Second Floor

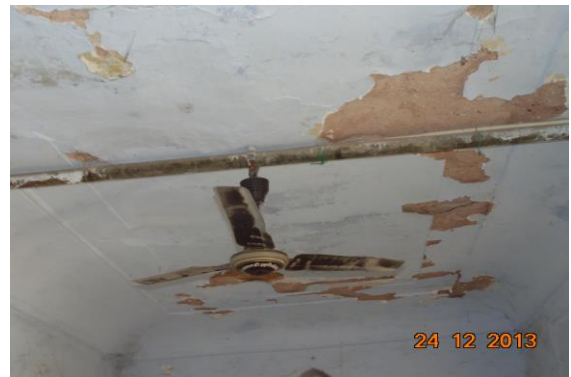
Photo 165

Peeling of Plaster on Wall No. 1 of Hall No. 4 (Part A) of Shahid Amit Bhardwaj School, Second Floor

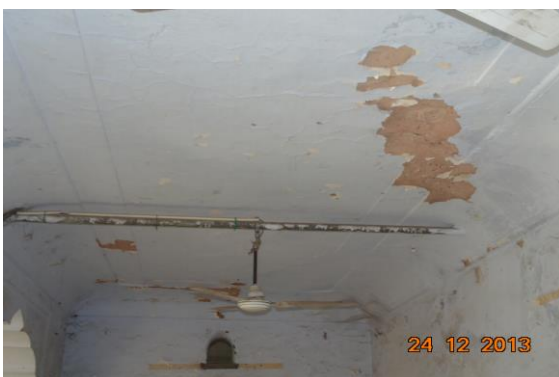
Photo 166

Peeling of Plaster on Wall No. 1 of Hall No. 4 (Part A) of Shahid Amit Bhardwaj School, Second Floor

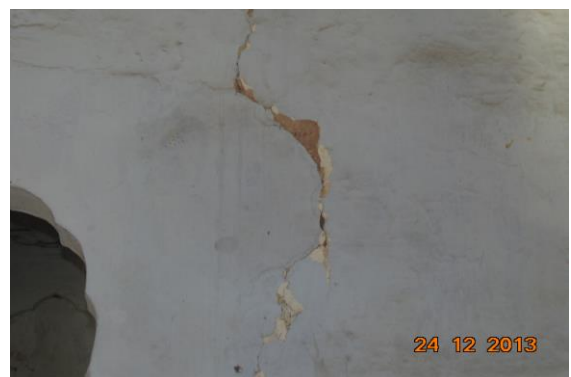
Photo 167

Peeling of Plaster on Wall No. 1 of Hall No. 4 (Part A) of Shahid Amit Bhardwaj School, Second Floor

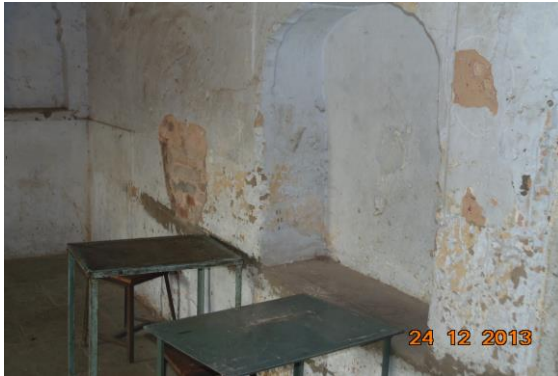
Photo 168

Peeling of Plaster on Wall No. 2 & 4 of Hall No. 4 (Part A) of Shahid Amit Bhardwaj School, Second Floor

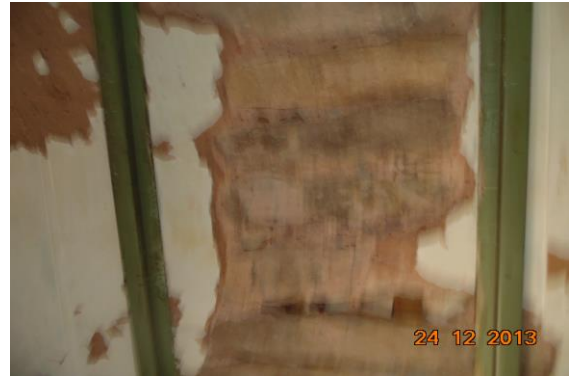
Photo 169

Peeling of Plaster on Roof of Hall No. 4 (Part B) of Shahid Amit Bhardwaj School, Second Floor

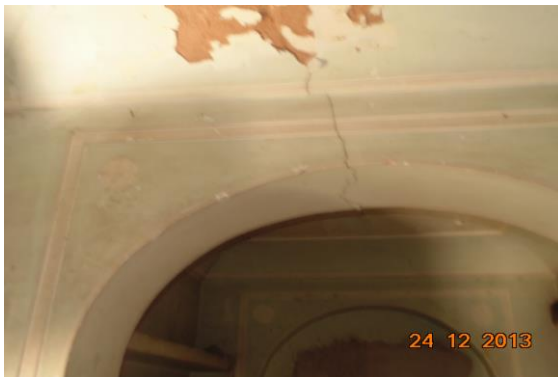
Photo 170

Peeling of Plaster on Roof of Hall No. 4 (Part B) of Shahid Amit Bhardwaj School, Second Floor

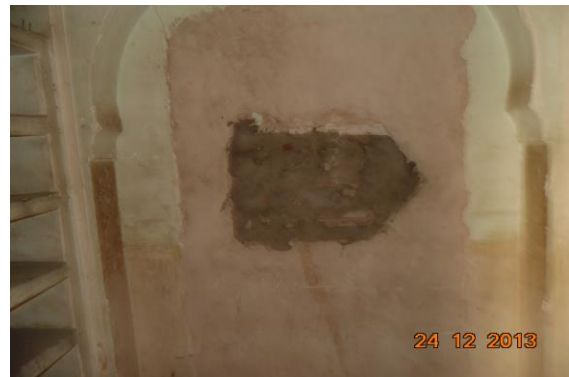
Photo 171

Peeling of Plaster on Wall No. 4 of Hall No. 4 (Part B) of Shahid Amit Bhardwaj School, Second Floor

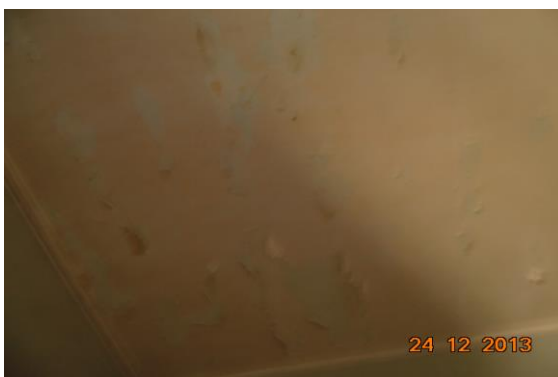
Photo 172

Damaged Portion on Roof of Room No. 6 (Part A) of Shahid Amit Bhardwaj School, Second Floor

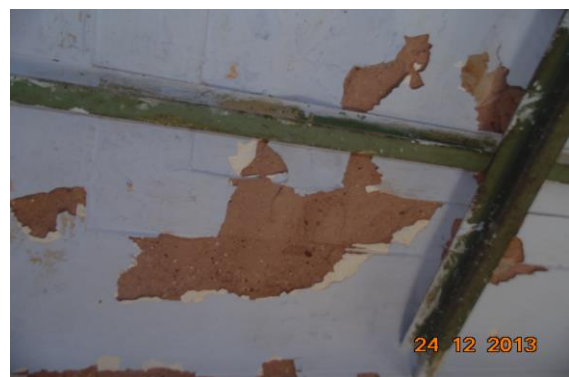
Photo 173

Damaged Portion on Wall No. 1 of Room No. 6 (Part A) of Shahid Amit Bhardwaj School, Second Floor

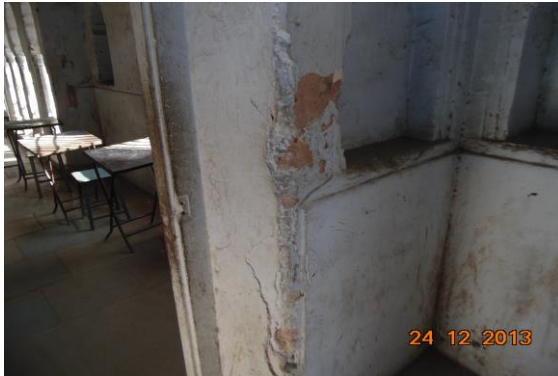
Photo 174

Damaged Portion on Wall No. 4 of Room No. 6 (Part A) of Shahid Amit Bhardwaj School, Second Floor

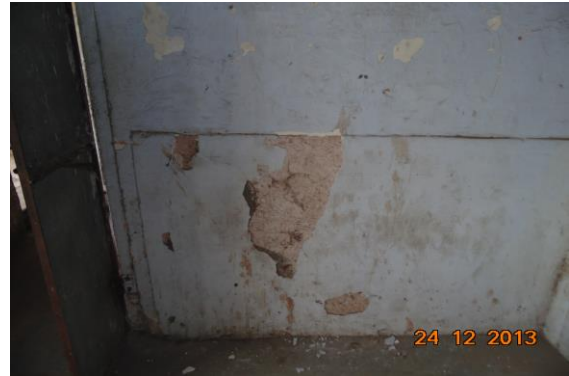
Photo 175

Peeling of Plaster on Wall No. 4 of Room No. 6 (Part B) of Shahid Amit Bhardwaj School, Second Floor

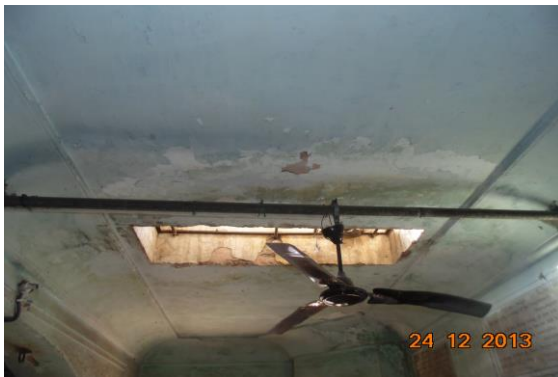
Photo 176

Peeling of Plaster on Roof of Room No. 6 (Part B) of Shahid Amit Bhardwaj School, Second Floor

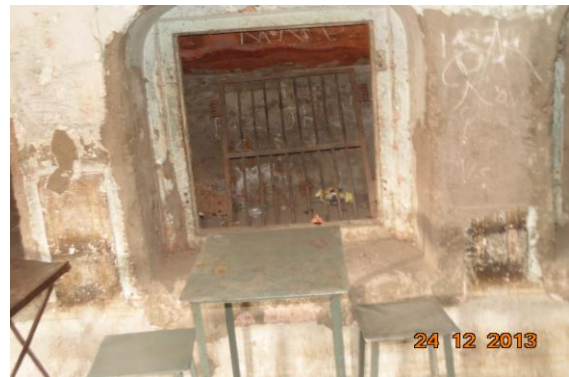
Photo 177

Peeling of Plaster on Roof of Lobby No.4 of Second Floor

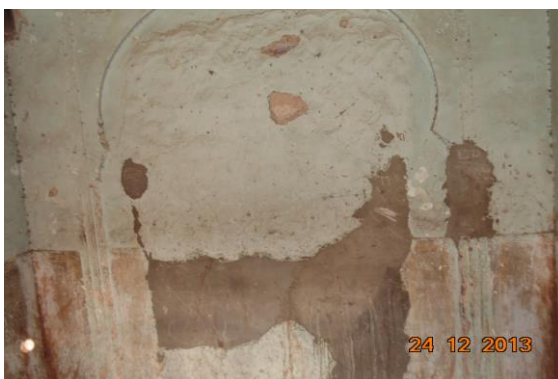
Photo 178

Peeling of Plaster on Wall No. 3 of Lobby No.4 of Second Floor

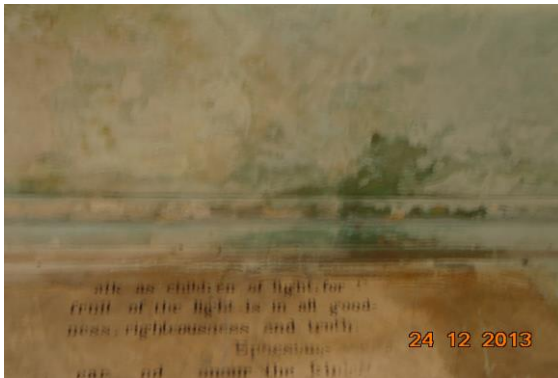
Photo 180

Dampness/Seepage on Roof of Room No. 7 (Part B) of Shahid Amit Bhardwaj School, Second Floor

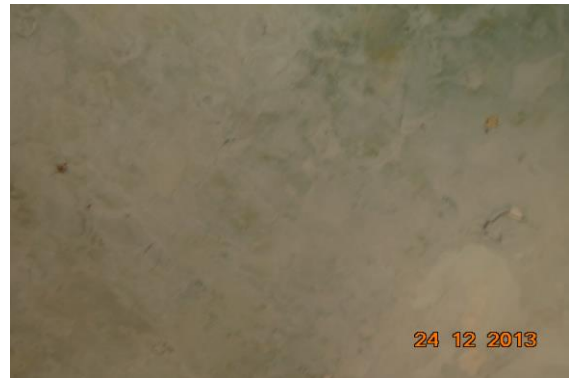
Photo 181

Peeling of Plaster on Wall No. 4 of Room No. 7 (Part B) of Shahid Amit Bhardwaj School, Second Floor

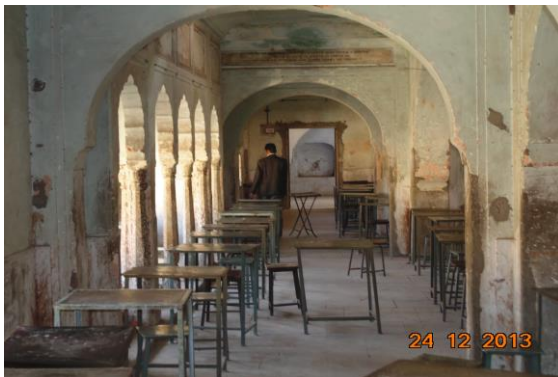
Photo 182

Peeling of Plaster on Wall No. 2 of Room No. 7 (Part B) of Shahid Amit Bhardwaj School, Second Floor

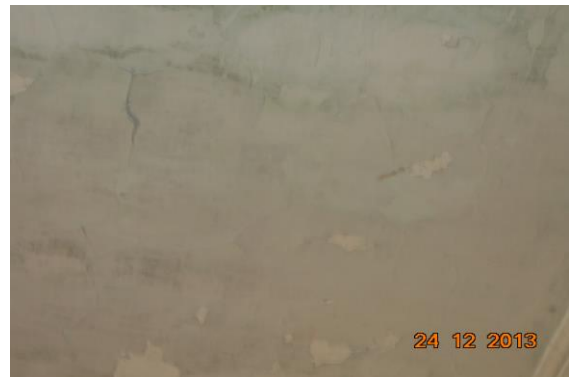
Photo 183

Peeling of Plaster on Wall No. 3 of Room No. 7 (Part B) of Shahid Amit Bhardwaj School, Second Floor

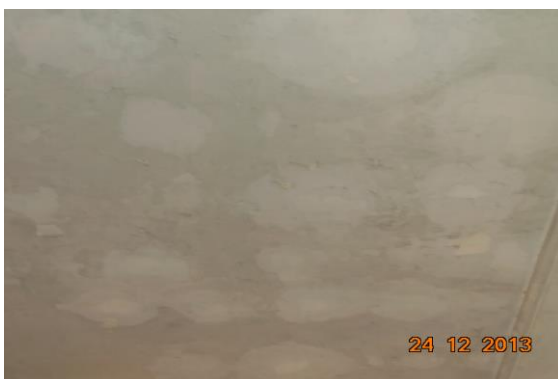
Photo 184

Dampness/Seepage on Wall No. 4 of Room No. 7 (Part A) of Shahid Amit Bhardwaj School, Second Floor

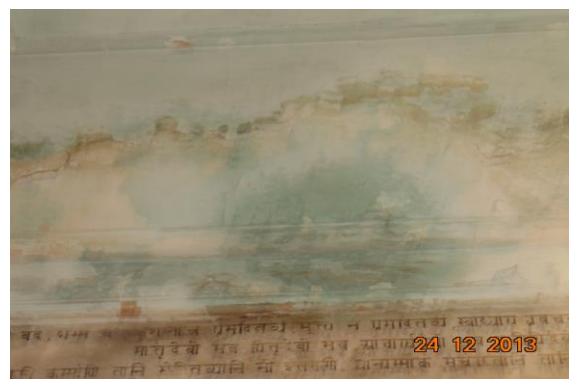
Photo 185

Dampness/Seepage on Roof of Room No. 7 (Part A) of Shahid Amit Bhardwaj School, Second Floor

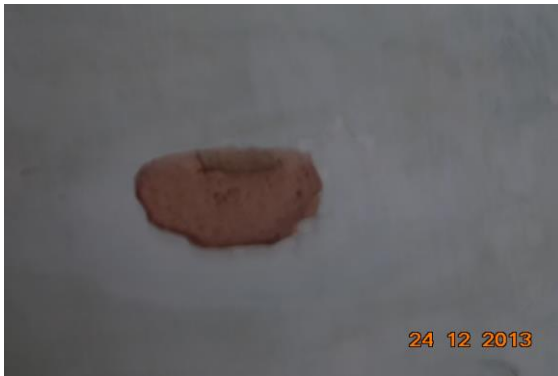
Photo 186

Peeling of Plaster on Wall No. 1 & 2 of Hall No. 5 (Part A) of Shahid Amit Bhardwaj School, Second Floor

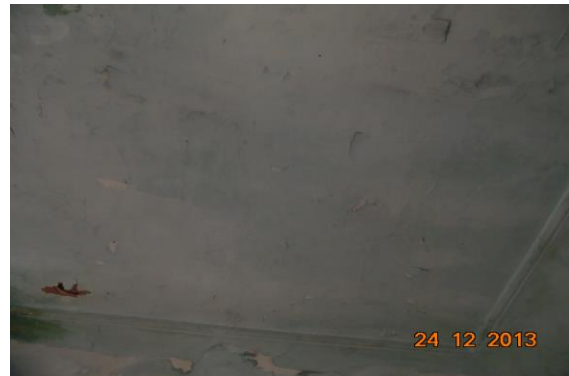
Photo 187

Dampness/Seepage on Roof of Hall No. 5 (Part A) of Shahid Amit Bhardwaj School, Second Floor

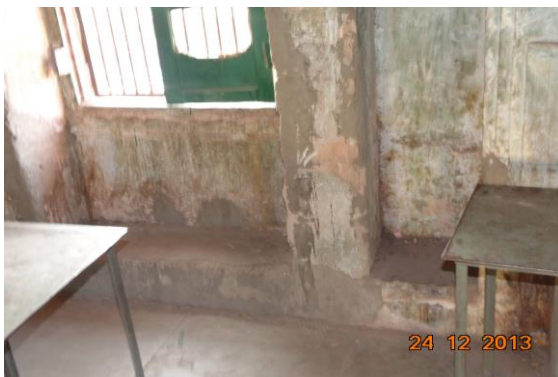
Photo 188

Dampness/Seepage on Roof of Hall No. 5 (Part A) of Shahid Amit Bhardwaj School, Second Floor

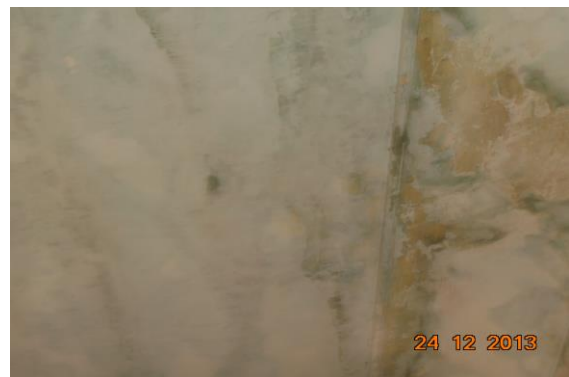
Photo 189

Dampness/Seepage on Roof of Hall No. 5 (Part A) of Shahid Amit Bhardwaj School, Second Floor

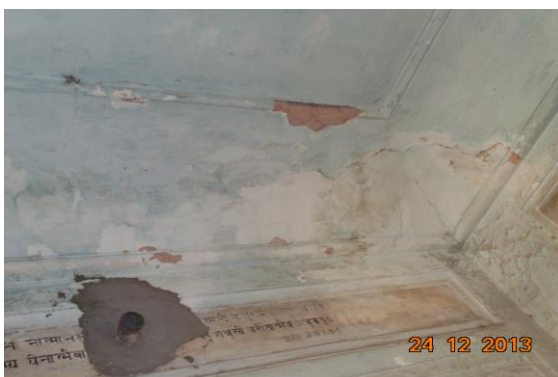
Photo 190

Dampness/Seepage on Roof of Hall No. 5 (PartB) of Shahid Amit Bhardwaj School, Second Floor

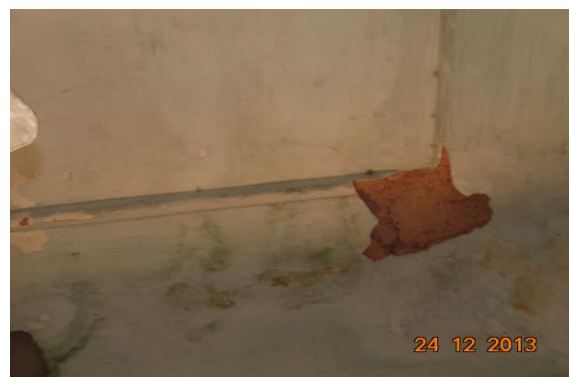
Photo 191

Dampness/Seepage on Roof of Hall No. 5 (PartB) of Shahid Amit Bhardwaj School, Second Floor

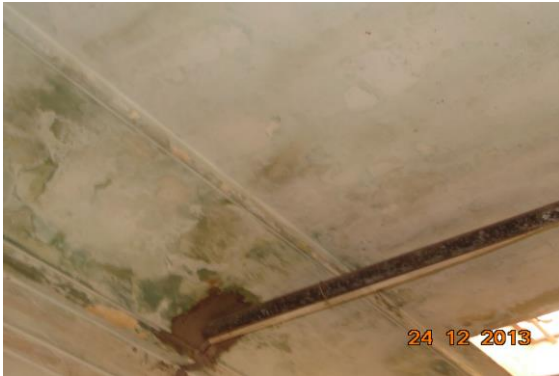
Photo 192

Peeling of Plaster on Wall No. 4 of Hall No. 5 (PartB) of Shahid Amit Bhardwaj School, Second Floor

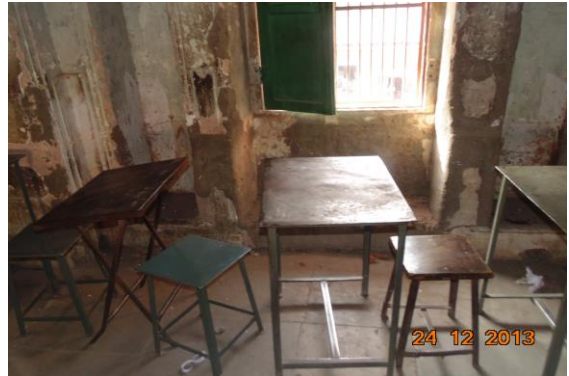
Photo 193

Dampness/Seepage on Roof of Hall No. 5 (PartB) of Shahid Amit Bhardwaj School, Second Floor

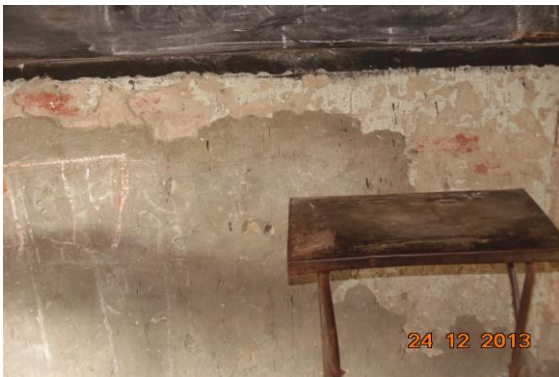
Photo 194

Dampness/Seepage on Wall No. 1, 4 & Roof of Hall No. 5 (PartB) of Shahid Amit Bhardwaj School, Second Floor

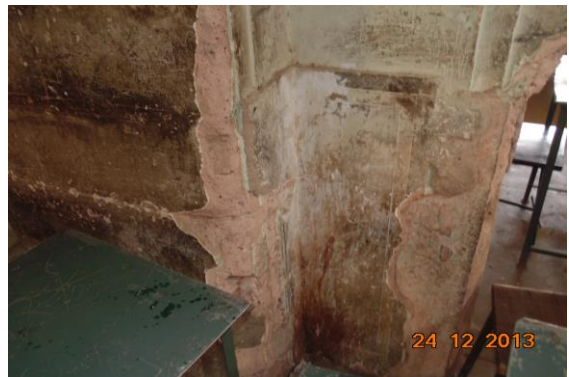
Photo 195

Dampness/Seepage on Roof of Hall No. 5 (PartB) of Shahid Amit Bhardwaj School, Second Floor

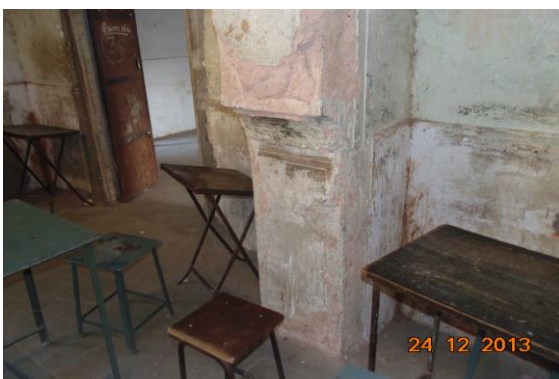
Photo 196

Dampness/Seepage on Roof of Hall No. 5 (PartB) of Shahid Amit Bhardwaj School, Second Floor

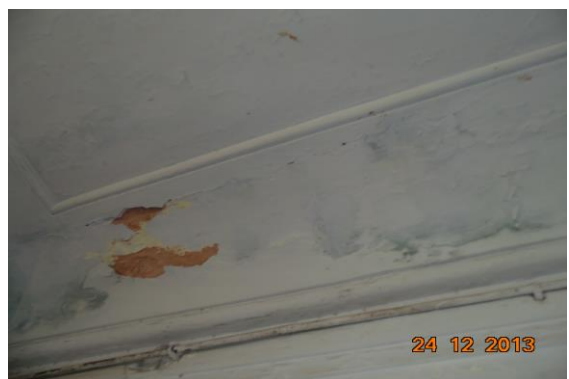
Photo 197

Dampness/Seepage on Roof of Hall No. 5 (PartB) of Shahid Amit Bhardwaj School, Second Floor
