Pre Building Condition Survey Report

Name and Address of Structure :	Badi Chopar Station Area
---------------------------------	--------------------------

Name of the Project	Contract JMRC-UG1B “Design and Construction of Tunnel between Chandpole and Badi Chouper and reverse line by Shield TBM, Underground Metro Stations at Choti Chouper and Badi Chouper by Cut and Cover Methods on East West Corridor of Jaipur Metro Rail Corporation Limited .”	
Owner :

Pre - Condition Building Survey for Construction of Underground Stations from Chandpole to Bari Chouper and reversal line

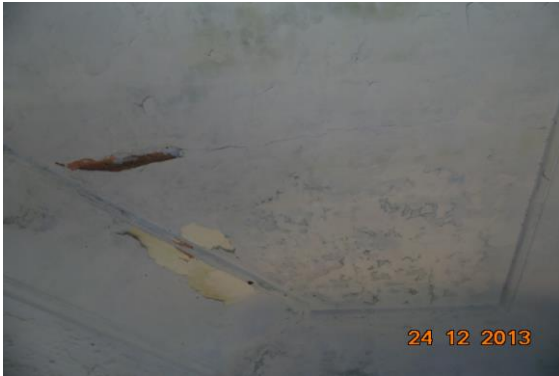
Photo 198

Peeling of Plaster on Wall No. 4 of Hall No. 5 (PartB) of Shahid Amit Bhardwaj School, Second Floor

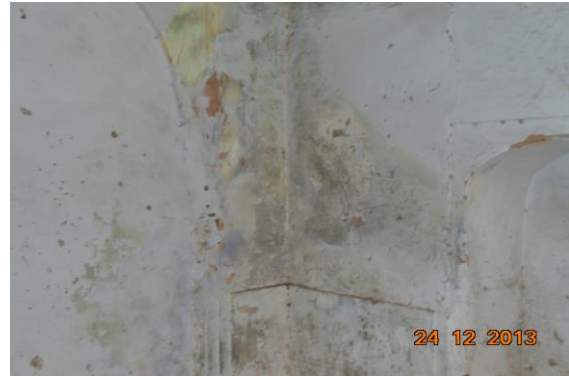
Photo 199

Peeling of Plaster on Wall No. 2 of Hall No. 5 (PartB) of Shahid Amit Bhardwaj School, Second Floor

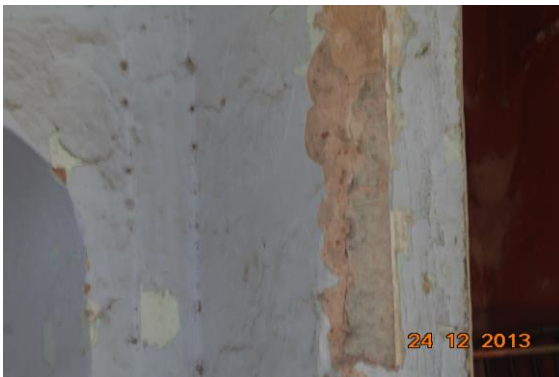
Photo 200

Peeling of Plaster on Wall No. 3 of Hall No. 5 (PartB) of Shahid Amit Bhardwaj School, Second Floor

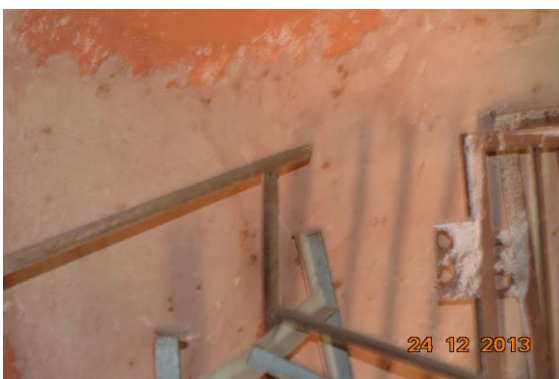
Photo 201

Peeling of Plaster on Wall No. 3 of Hall No. 5 (PartB) of Shahid Amit Bhardwaj School, Second Floor

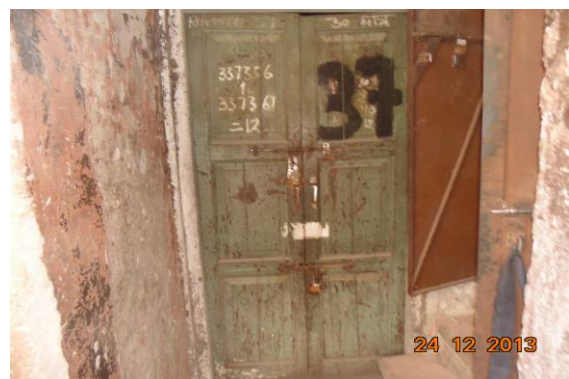
Photo 202

Dampness/Seepage on Roof of Room No. 8 of Shahid Amit Bhardwaj School, Second Floor

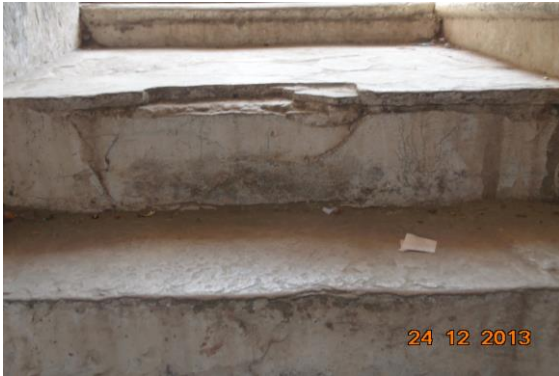
Photo 203

Dampness/Seepage on Wall No. 1 & 4 of Room No. 8 of Shahid Amit Bhardwaj School, Second Floor

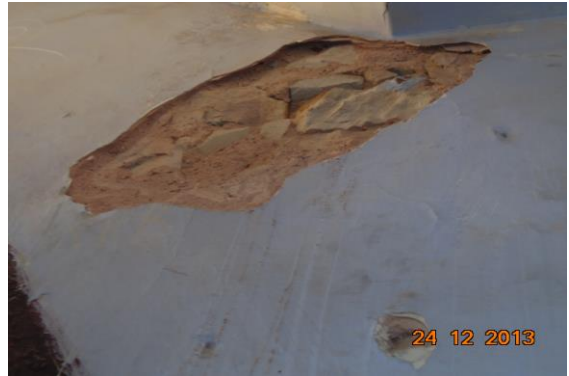
Photo 204

Peeling of Plaster on Wall No. 4 of Room No. 8 of Shahid Amit Bhardwaj School, Second Floor

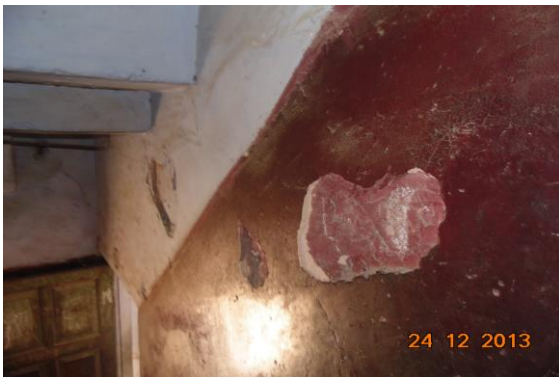
Photo 205

Peeling of Plaster on Wall No. 2 of Room No. 8 of Shahid Amit Bhardwaj School, Second Floor

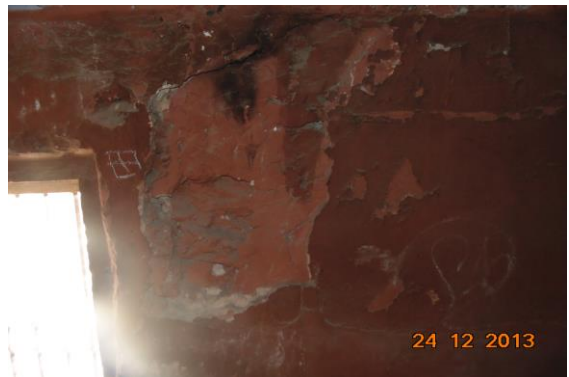
Photo 206

Peeling of Plaster on Wall No. 4 of Tomb No.2 of Second Floor

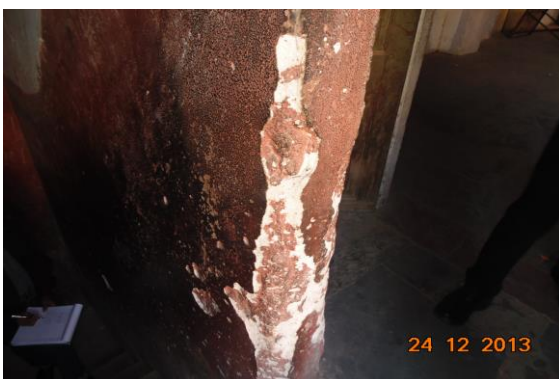
Photo 207

Damaged Portion on Staircase No.2 First Floor to Second Floor

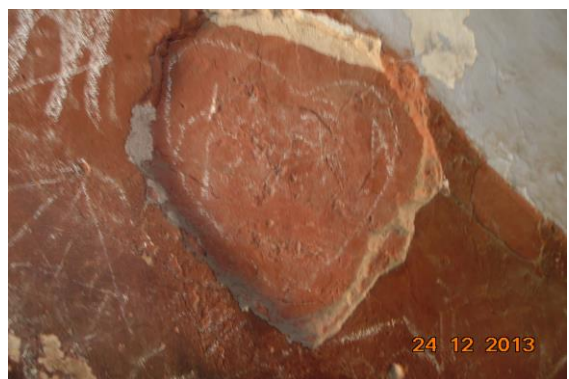
Photo 208

Peeling of Plaster on Wall No. 2 of Staircase No.2 First Floor to Second Floor

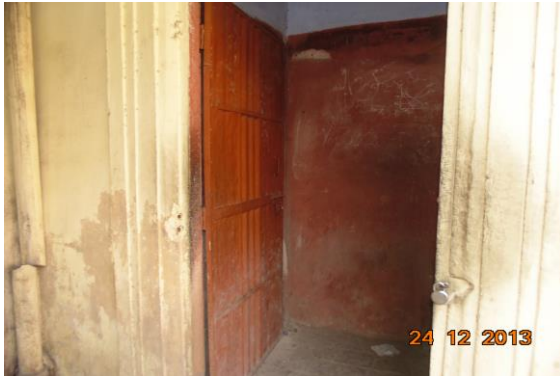
Photo 209

Peeling of Plaster on Wall No. 1 of Staircase No.2 First Floor to Second Floor

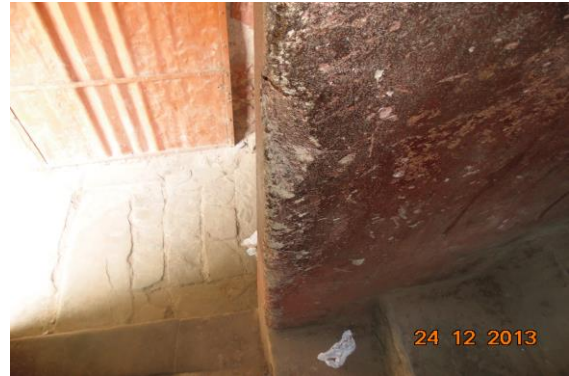
Photo 210

Peeling of Plaster on Roof of Staircase No.2 First Floor to Second Floor

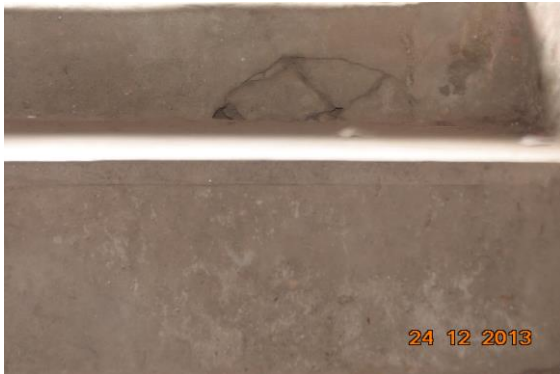
Photo 211

Peeling of Plaster on Wall No. 3 of Staircase No.2 First Floor to Second Floor

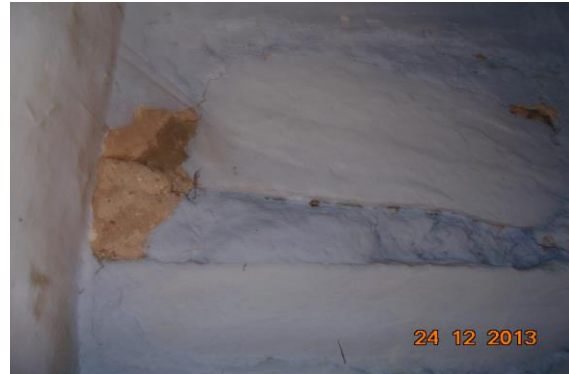
Photo 212

Peeling of Plaster on Wall No. 1 of Staircase No.2 Ground Floor to First Floor

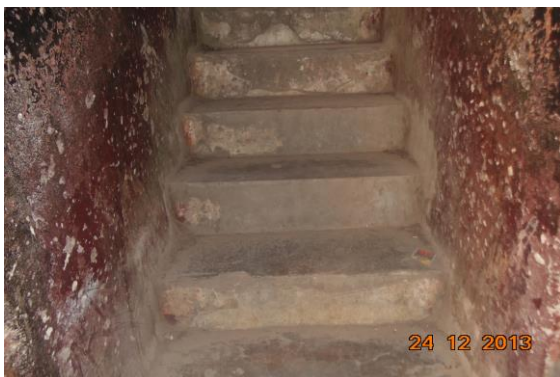
Photo 213

Peeling of Plaster on Wall No. 2 of Staircase No.2 Ground Floor to First Floor

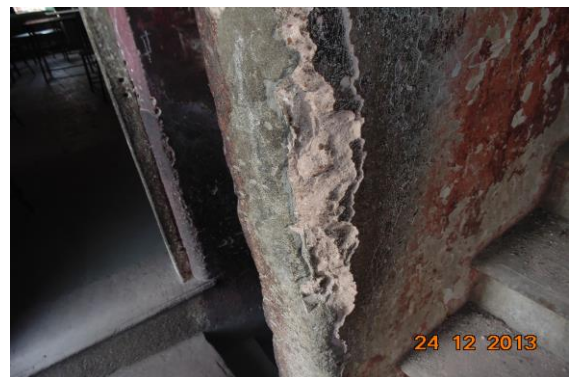
Photo 214

Peeling of Plaster on Wall No. 1 & 4 of Staircase No.2 Ground Floor to First Floor

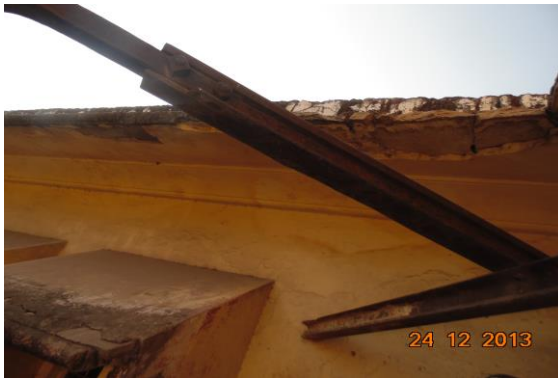
Photo 215

Peeling of Plaster on Wall No. 1 of Staircase No.2 Ground Floor to First Floor

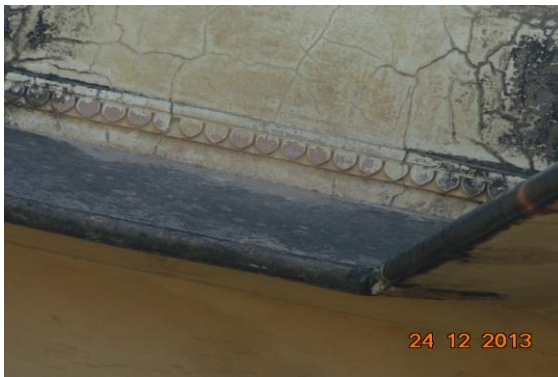
Photo 217

Damaged Portion on Roof of Staircase No.2 Ground Floor to First Floor

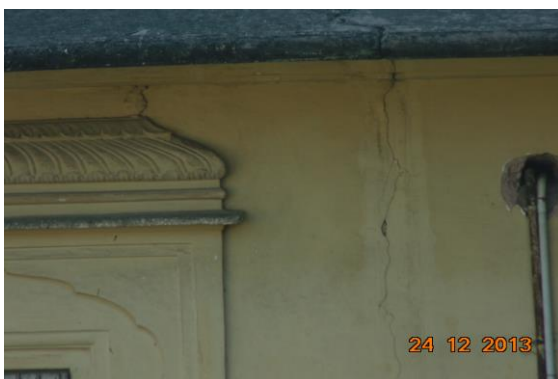
Photo 219

Peeling of Plaster on Wall No. 1 of Staircase No.1 First Floor to Second Floor

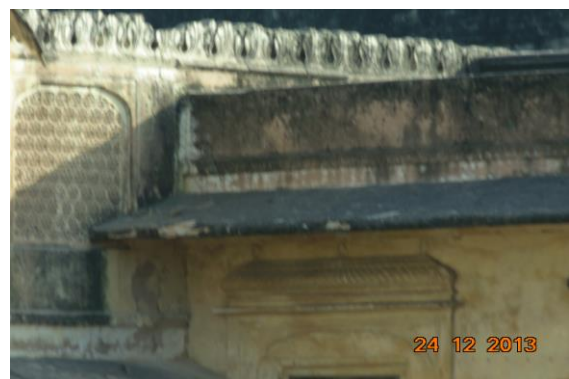
Photo 220

Damaged Portion on Wall No. 3 & Shade of Open Sky of Second Floor

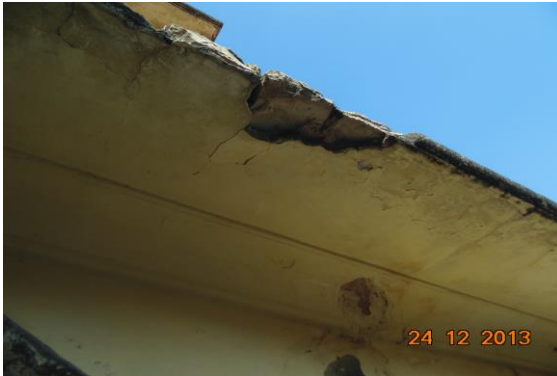
Photo 221

Damaged Portion on Wall No. 3 & Shade of Open Sky of Second Floor

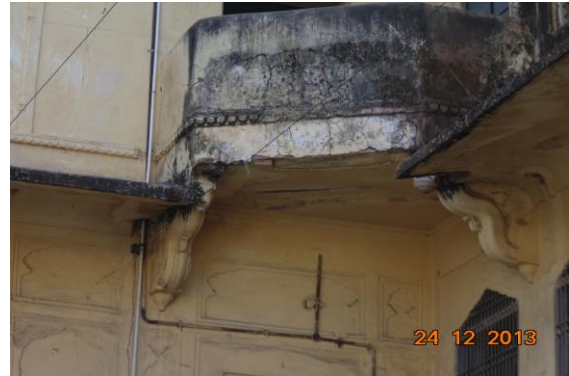
Photo 222

Damaged Portion on Wall No. 3 & Shade of Open Sky of Second Floor

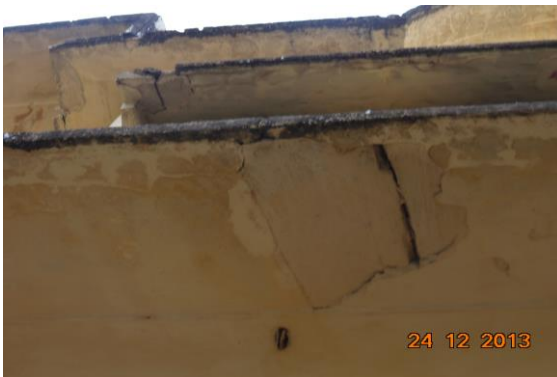
Photo 223

Damaged Portion on Wall No. 2 & Shade of Open Sky of Second Floor

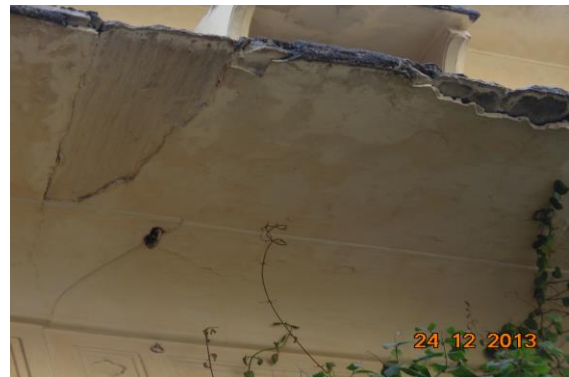
Photo 224

Damaged Portion on Wall No. 1 & Shade of Open Sky of Second Floor

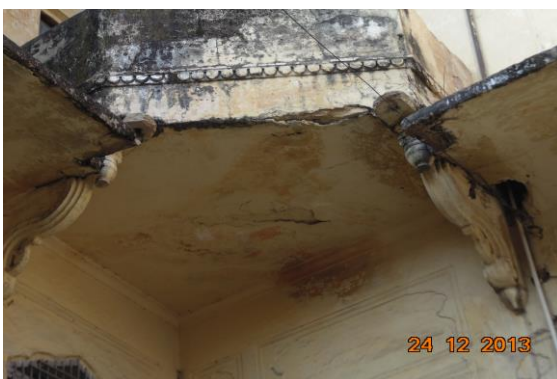
Photo 225

Damaged Portion on Wall No. 1 & Shade of Open Sky of Second Floor

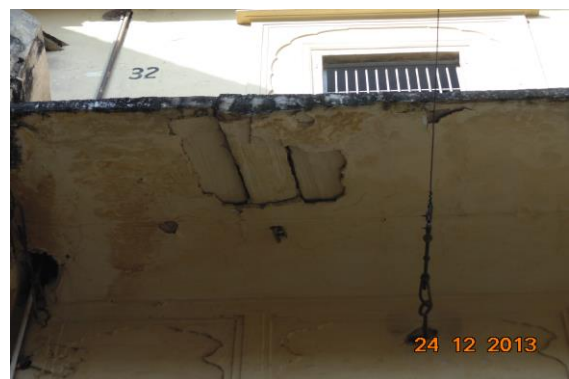
Photo 226

Damaged Portion on Wall No. 1 & Shade of Open Sky of Second Floor

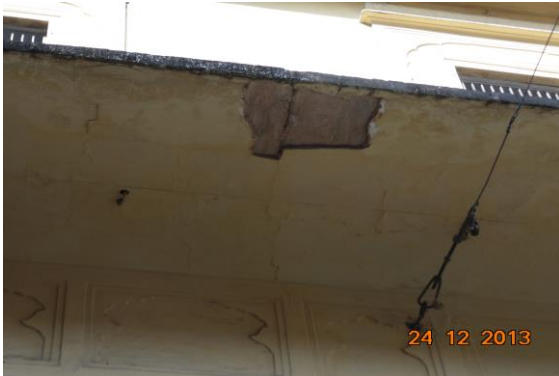
Photo 227

Damaged Portion on Wall No. 2, 3 & Shade of Open Sky of First Floor

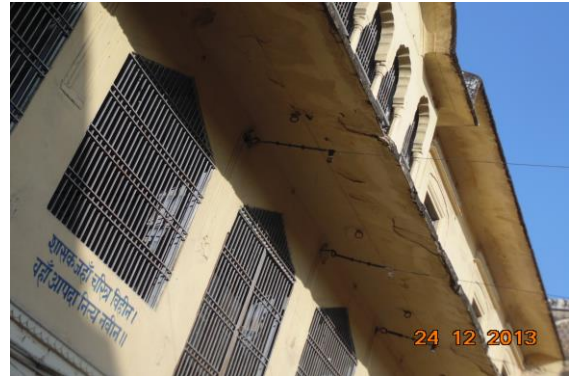
Photo 228

Damaged Portion on Wall No. 3 & Shade of Open Sky of First Floor

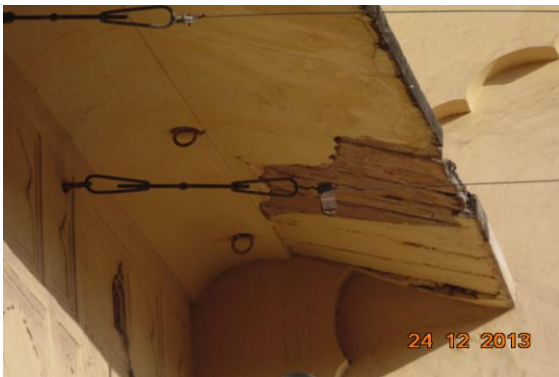
Photo 229

Damaged Portion on Wall No. 3 & Shade of Open Sky of First Floor

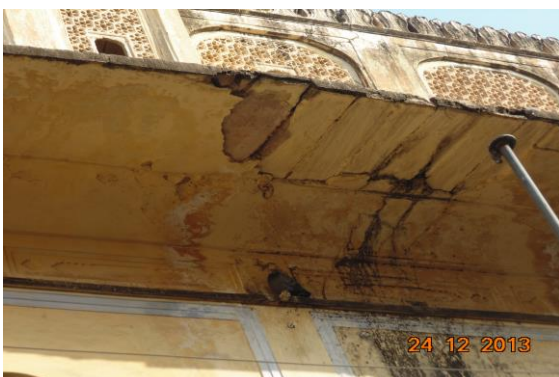
Photo 231

Damaged Portion on Wall No. 1 & Shade of Balcony of First Floor

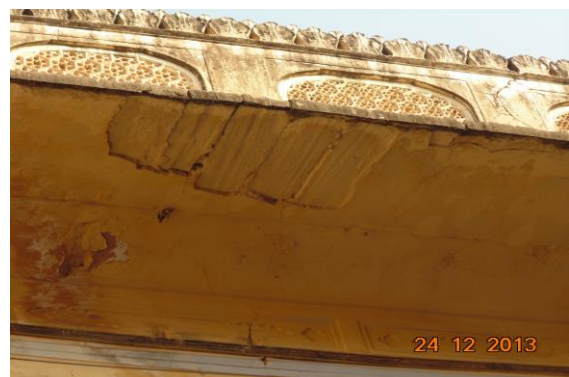
Photo 232

Damaged Portion on Wall No. 1 & Shade of Balcony of First Floor

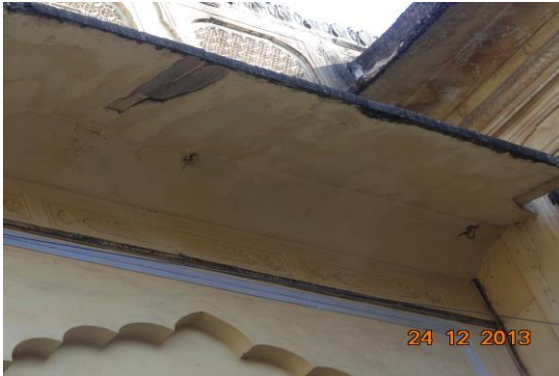
Photo 233

Damaged Portion on Wall No. 1 & Shade of Balcony of First Floor

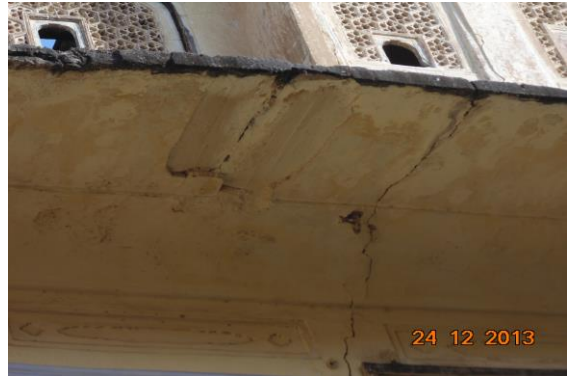
Photo 234
Damaged Portion on Wall No. 1 & Shade of Balcony of First Floor

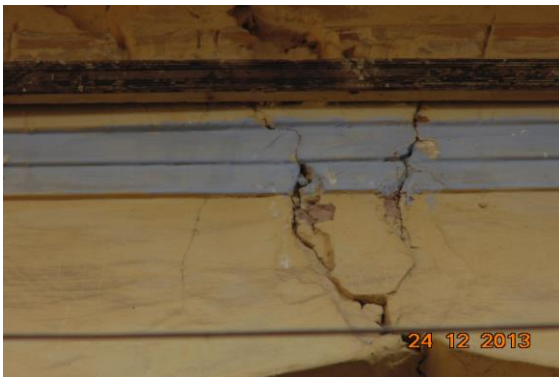
Photo 235
Damaged Portion on Wall No. 4 & Shade of Balcony of First Floor

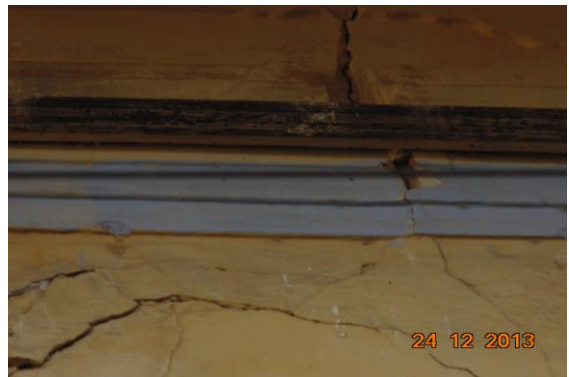
Photo 236
Damaged Portion on Wall No. 4 & Shade of Balcony of First Floor

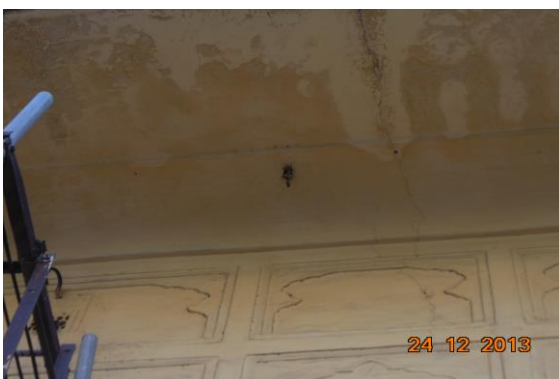
Photo 237
Damaged Portion on Wall No. 4 & Shade of Balcony of First Floor

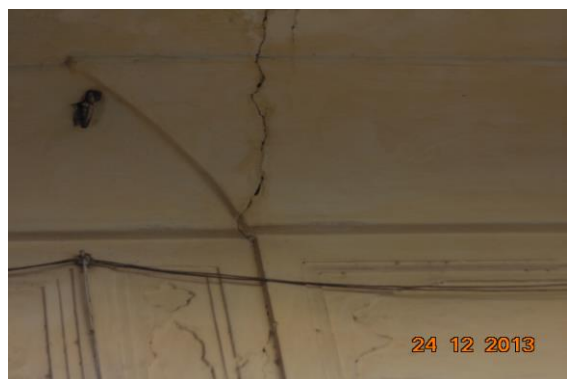
Photo 238
Damaged Portion on Wall No. 4 & Shade of Balcony of First Floor

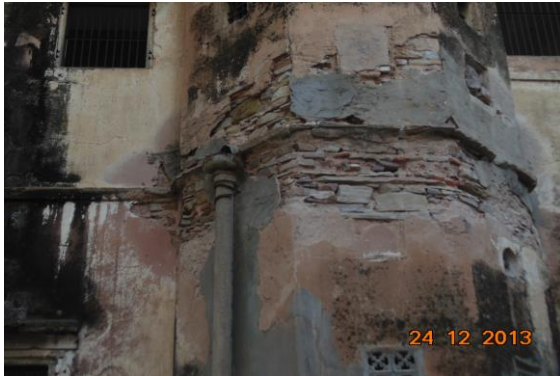
Photo 239
Damaged Portion on Wall No. 4 of Balcony of First Floor

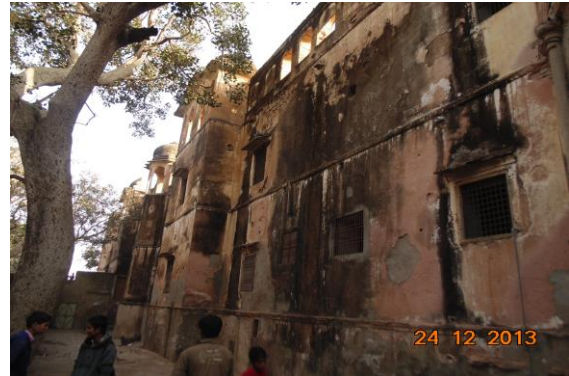
Photo 240
Damaged Portion on First Floor

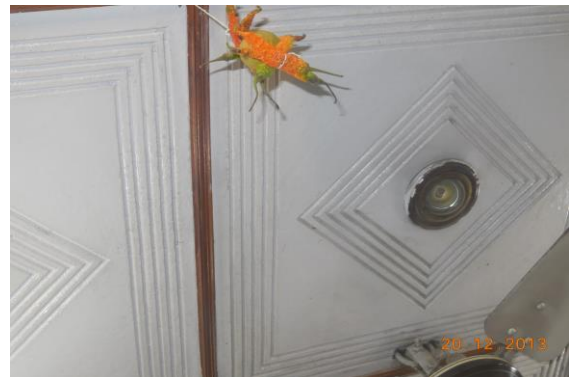
Photo 242
All walls of Shop No. 8 of Ground Floor Covered with Material

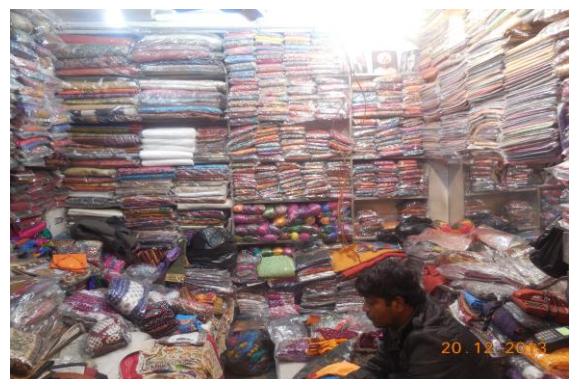
Photo 244
All walls of Shop No. 7 of Ground Floor Covered with Material

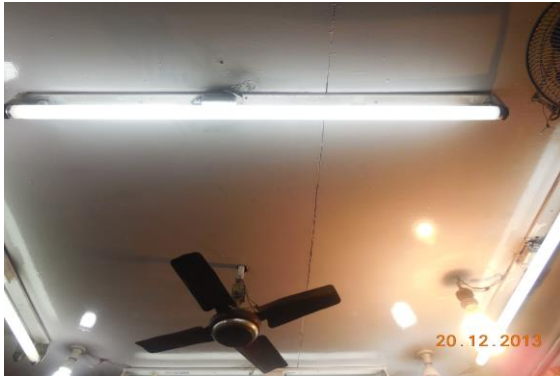
Photo 246
Roof of Shop No. 6 of Ground Floor Covered with Wooden

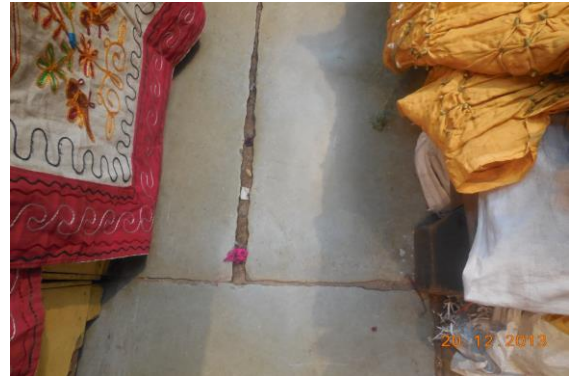
Photo 247
Floor of Shop No. 6 of Ground Floor

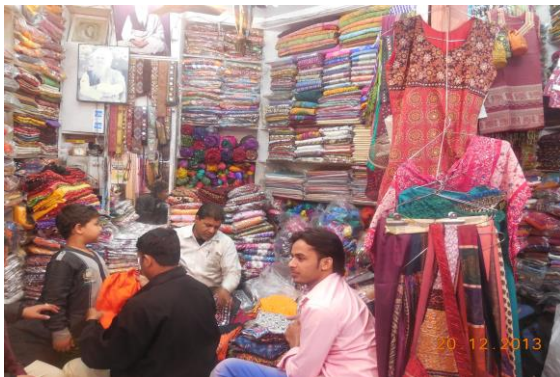
Photo 248
All walls of Shop No. 5 of Ground Floor Covered with Material

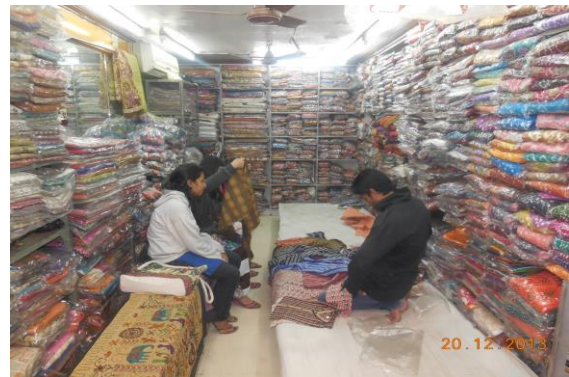
Photo 249
All walls of Shop No. 4 of Ground Floor Covered with Material

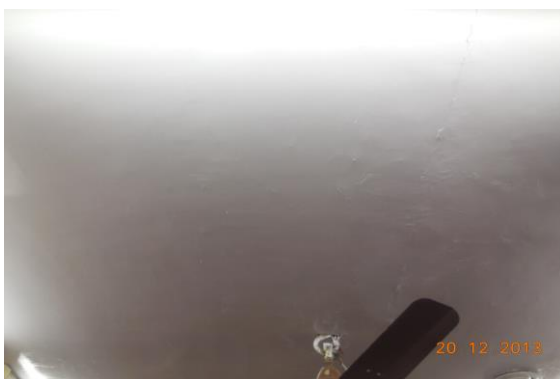
Photo 250
Roof of Shop No. 4 of Ground Floor Covered with Falls ceiling

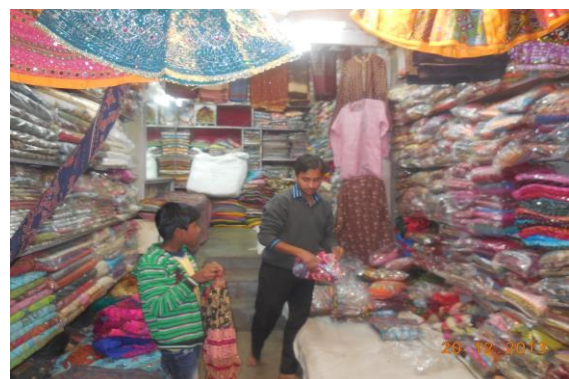
Photo 251
All walls of Shop No. 3 of Ground Floor View of shop Roof textiles

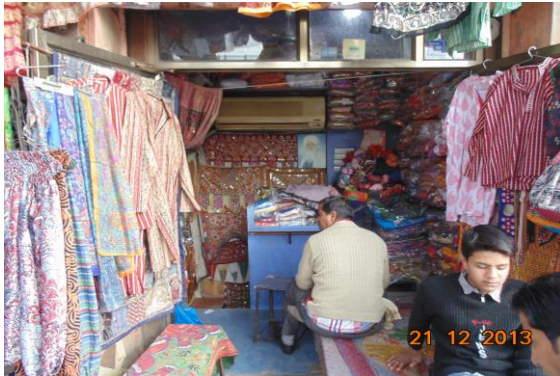
Photo 252

All Walls of Keshi international of Ground Floor Covered with Material

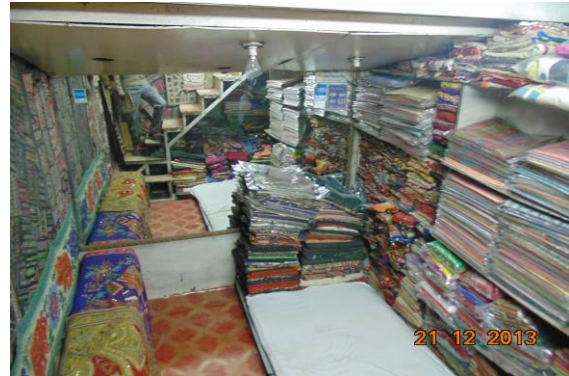
Photo 253

All Walls of Keshi international of Basement Covered with Material

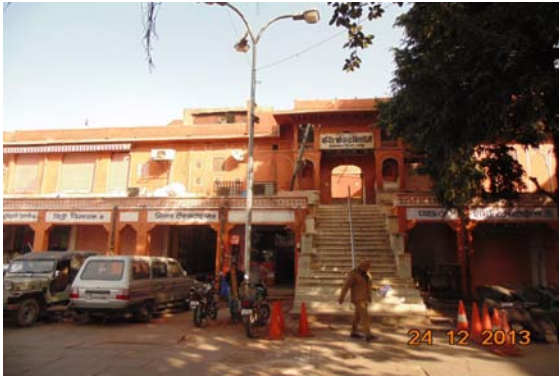
Photo 1
View of Temple Shri Chandra Vihari Ji

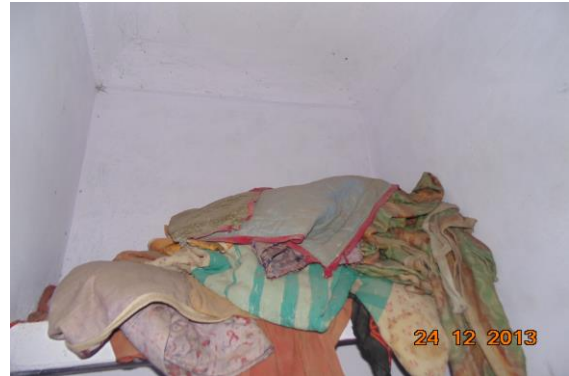
Photo 2
View of Room No.3, Temple Shri Chandra Vihari Ji, First Floor

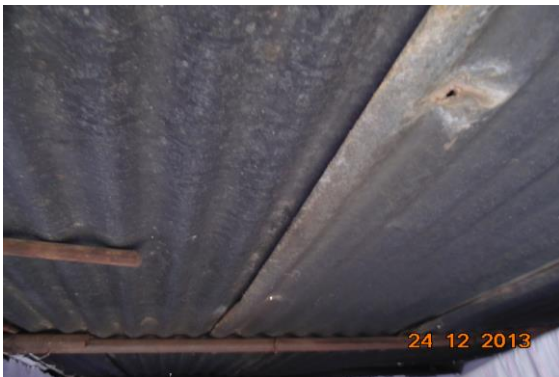
Photo 3
View of Tinshed Varanda , Third Floor

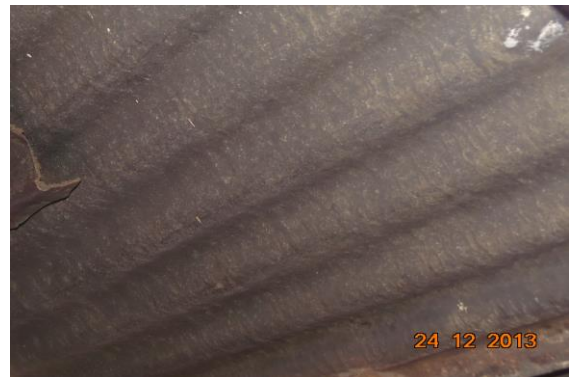
Photo 4
View of Kitchen, Third Floor

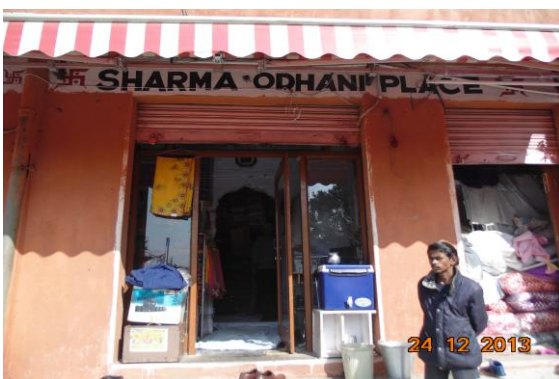
Photo 5
View of Sharma Odhani palace, First Floor

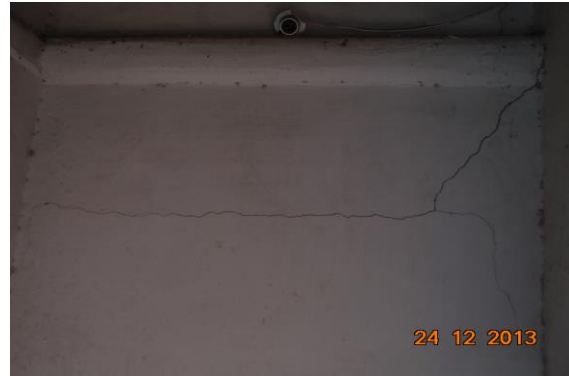
Photo 14
Inclined Crack on Wall No. 2 of Bathroom No. 1, Temple Shri Chandra Vihari Ji, First Floor, Approx. Width = 0.6mm, Approx. Length = 1m. Distance from Wall No. 4 = 0m, Height from Floor = 1.7m.

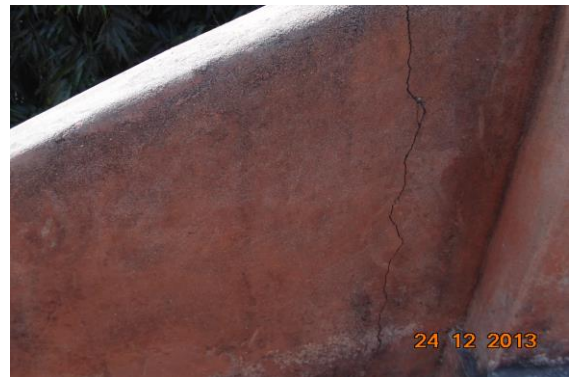
Photo 15
Inclined Crack on Wall No. 2 of Second Floor, Approx. Width = 2mm, Approx. Length = 1.5m. Distance from Wall No. 3 = 0.1m, Height from Floor = 0m.

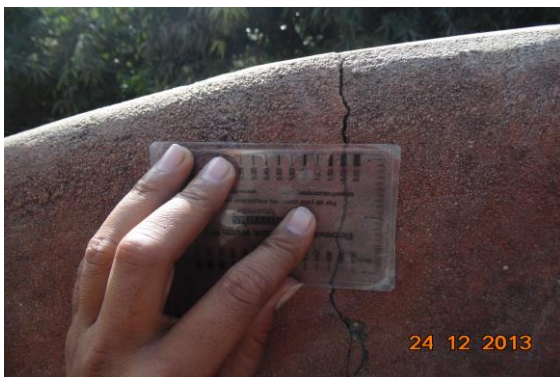
Photo 15A
Inclined Crack on Wall No. 2 of Second Floor, Approx. Width = 2mm, Approx. Length = 1.5m. Distance from Wall No. 3 = 0.1m, Height from Floor = 0m.

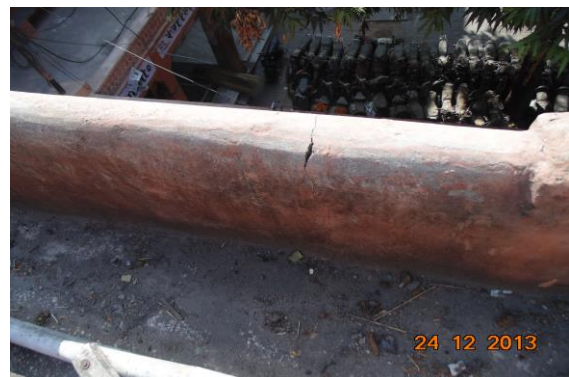
Photo 16
Inclined Crack on Wall No. 2 of Second Floor, Approx. Width = 0.6mm, Approx. Length = 1m. Distance from Wall No. 3 = 3.1m, Height from Floor = 0m.

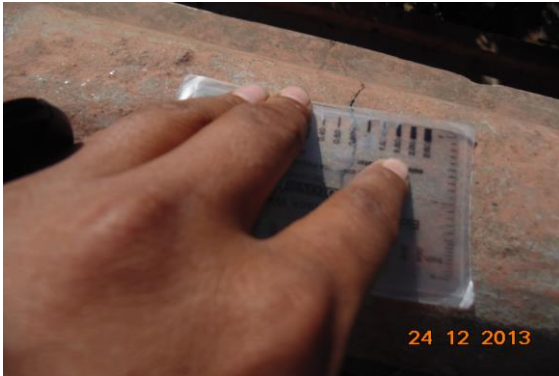
Photo 16A

Inclined Crack on Wall No. 2 of , Second Floor, Approx. Width = 0.6mm, Approx. Length = 1m., Distance from Wall No.3 = 3.1m, Height from Floor = 0m.

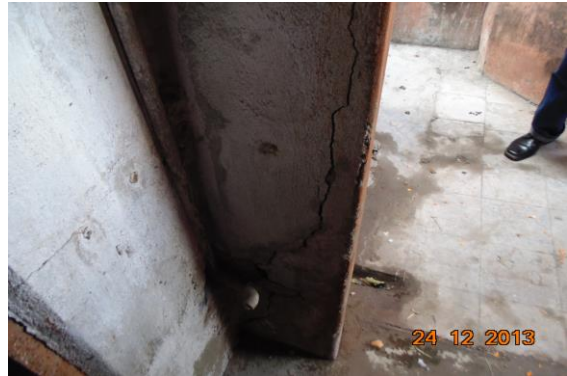
Photo 17

Inclined Crack on Wall No. 3 of Toilet & Washroom, Third Floor, Approx. Width = 5mm, Approx. Length = 1m., Distance from Wall No.2 = 0.3m, Height from Floor = 0m.

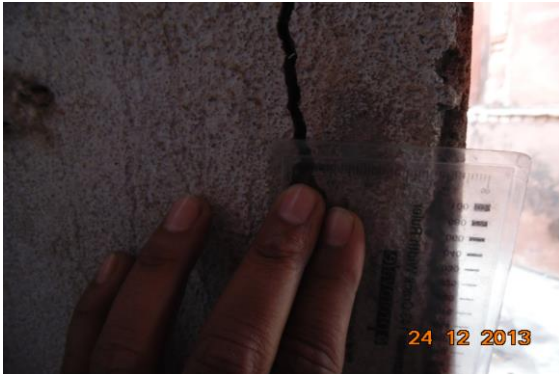
Photo 17A

Inclined Crack on Wall No. 3 of Toilet & Washroom, Third Floor, Approx. Width = 5mm, Approx. Length = 1m., Distance from Wall No.2 = 0.3m, Height from Floor = 0m.

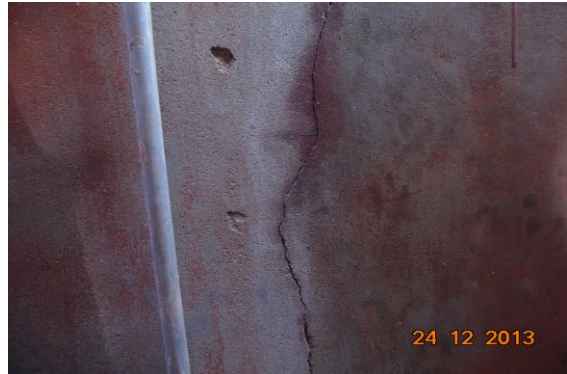
Photo 18

Inclined Crack on Wall No. 1 of Bathroom, Third Floor, Approx. Width = 0.8mm, Approx. Length = 2m., Distance from Wall No.3 = 2m, Height from Floor = 0m.

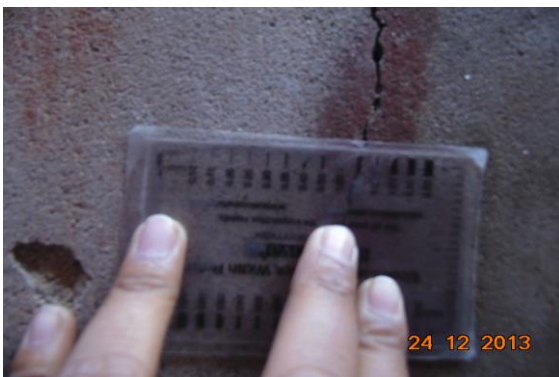
Photo 18A

Inclined Crack on Wall No. 1 of Bathroom , Third Floor, Approx. Width = 0.8mm, Approx. Length = 2m., Distance from Wall No.3 = 2m, Height from Floor = 0m.

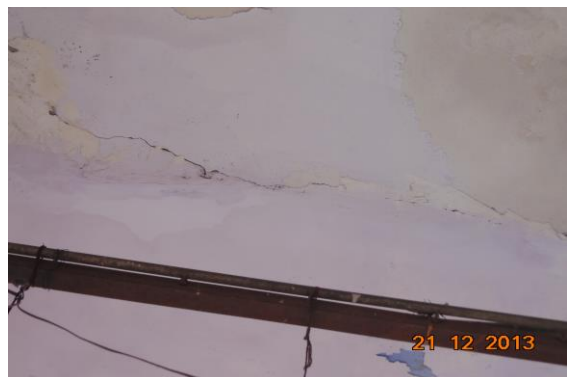
Photo 19

Horizontal Crack on Roof of Varanda of shop, Ground Floor, Approx. Width = 1mm, Approx. Length = 2.5m., Distance from Left side External Column = 0m, Height from Floor = 3m.

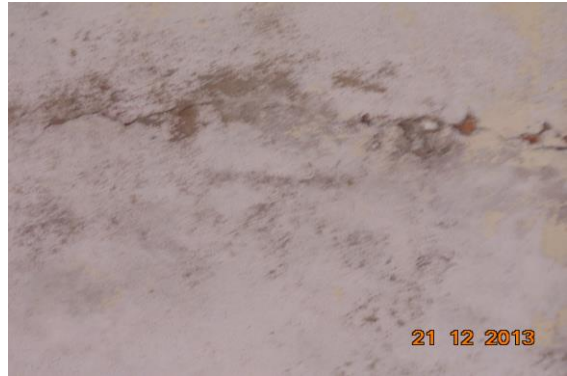
Photo 21

Horizontal Crack on Roof of Varanda of shop, Ground Floor, Approx. Width = 1mm, Approx. Length = 2.5m., Distance from Left side External Column = 1m, Height from Floor = 3m.

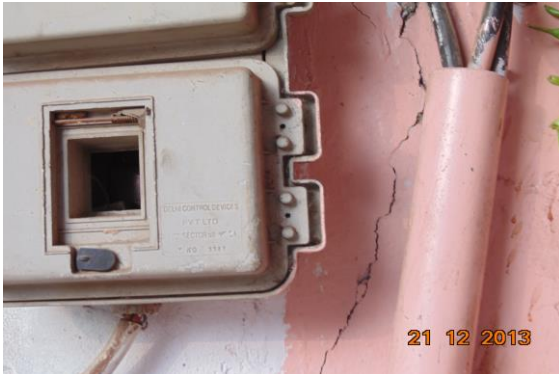
Photo 22

Inclined Crack on Left side External Column of Varanda of shop, Ground Floor, Approx. Width = 0.3mm, Approx. Length = 1.2m., Distance from Left side External Column = 0m, Height from Floor = 0.3m.

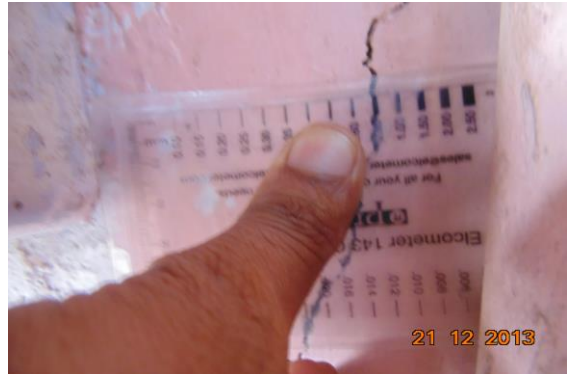
Photo 22A

Inclined Crack on Left side External Column of Varanda of shop, Ground Floor, Approx. Width = 0.3mm, Approx. Length = 1.2m., Distance from Left side External Column = 0m, Height from Floor = 0.3m.

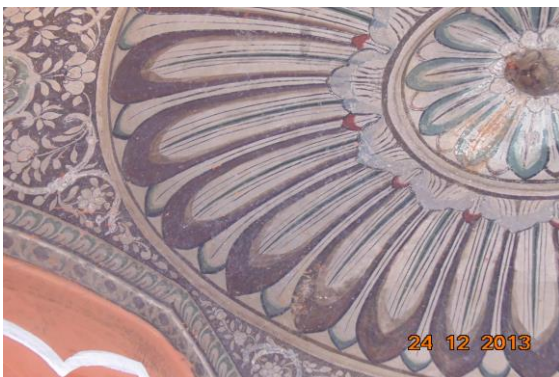
Photo 23

Dampness/Seepage on Roof & Right side Tomb of Temple Shri Chandra Vihari Ji of First Floor

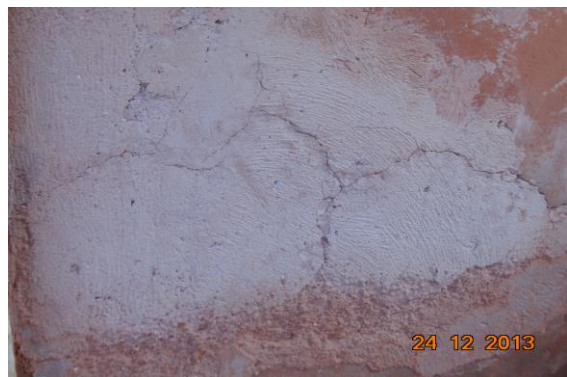
Photo 24

Peeling of Plaster on Wall No. 1 & Right side Tomb of Temple Shri Chandra Vihari Ji of First Floor

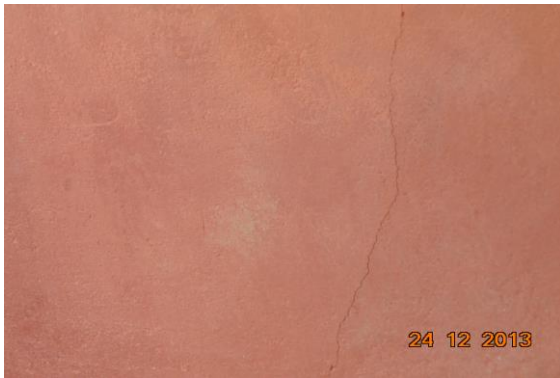
Photo 25

Peeling of Plaster on Wall No. 2 & Left side Tomb of Temple Shri Chandra Vihari Ji of First Floor

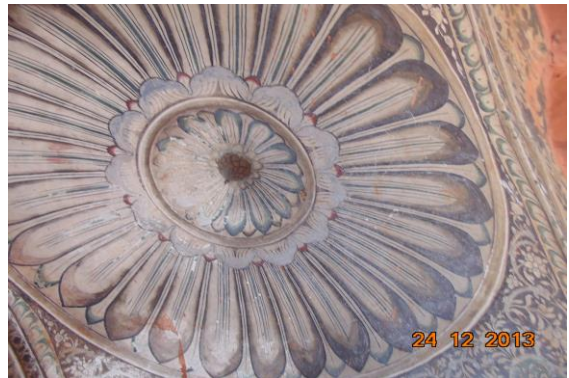
Photo 26

Dampness/Seepage on Roof & Left side Tomb of Temple Shri Chandra Vihari Ji of First Floor

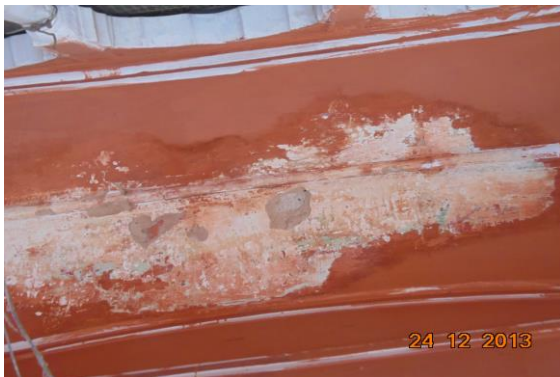
Photo 27

Dampness/Seepage on Roof & Main gate of Temple Shri Chandra Vihari Ji of First Floor

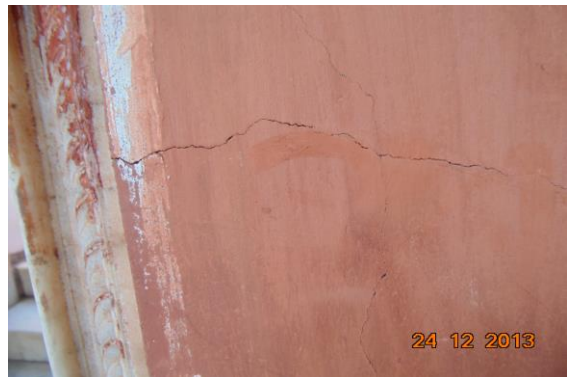
Photo 28

Peeling of Plaster on Wall No. 3 & Right side Tomb of Temple Shri Chandra Vihari Ji of First Floor

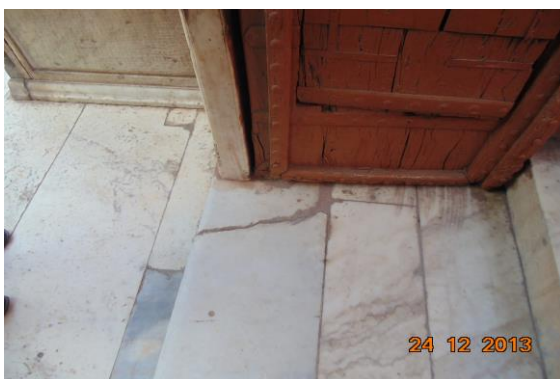
Photo 29

Damaged Portion on Floor of Temple Shri Chandra Vihari Ji of First Floor

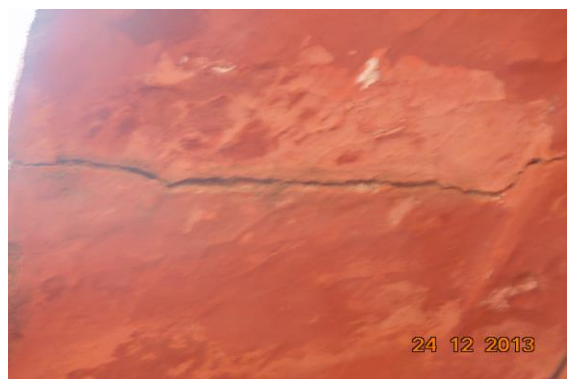
Photo 30

Damaged Portion on Wall No. 1 & Shade of Varanda of First Floor

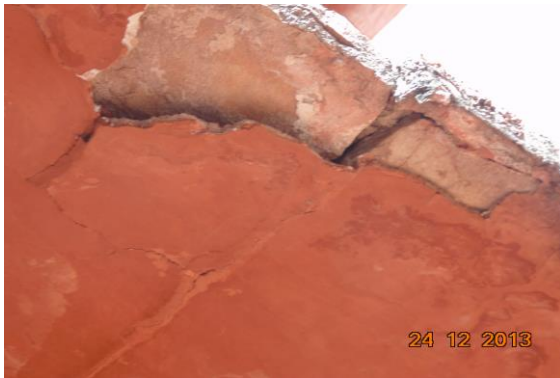
Photo 31

Damaged Portion on Wall No. 1 & Shade of Varanda of First Floor

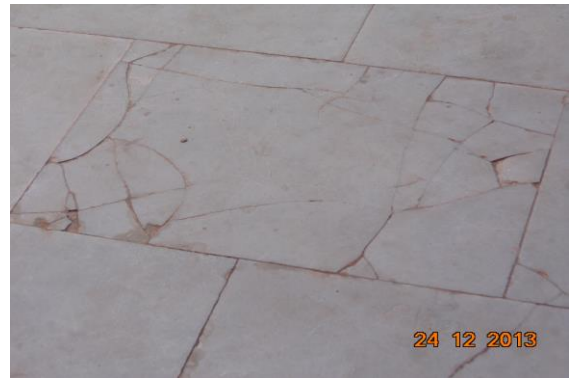
Photo 32

Damaged Portion on Floor of Varanda of First Floor

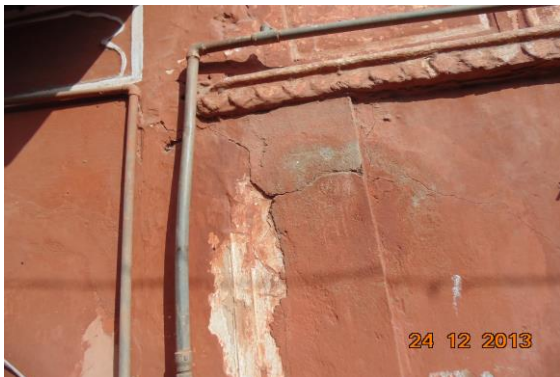
Photo 33

Peeling of Plaster on Wall No. 4 of Varanda of First Floor

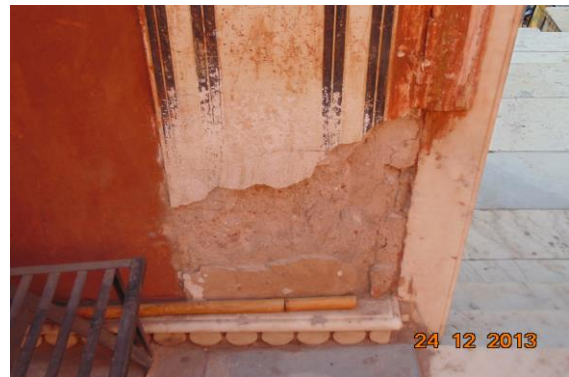
Photo 34

Peeling of Plaster on Wall No. 3 of Varanda of First Floor

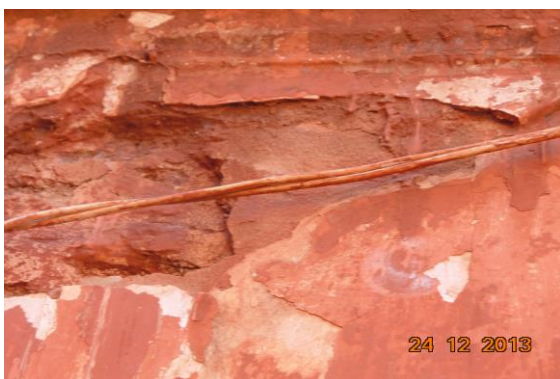
Photo 35

Peeling of Plaster on Wall No. 3 of Varanda of First Floor

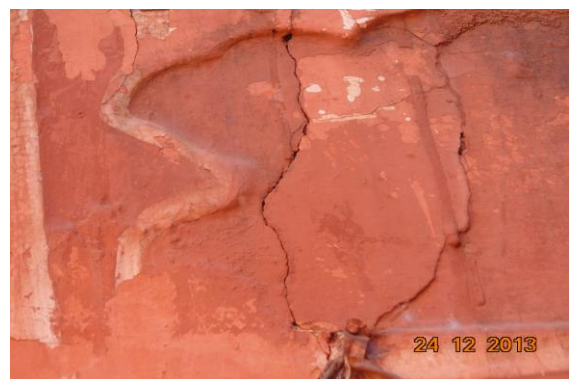
Photo 36

Peeling of Plaster on Wall No. 2 of Varanda of First Floor

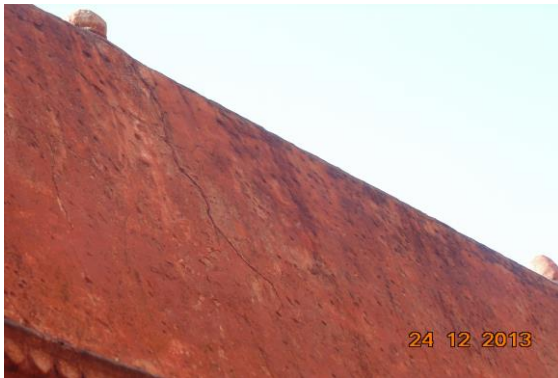
Photo 37

Peeling of Plaster on Outer Wall No.3 of Varanda of First Floor

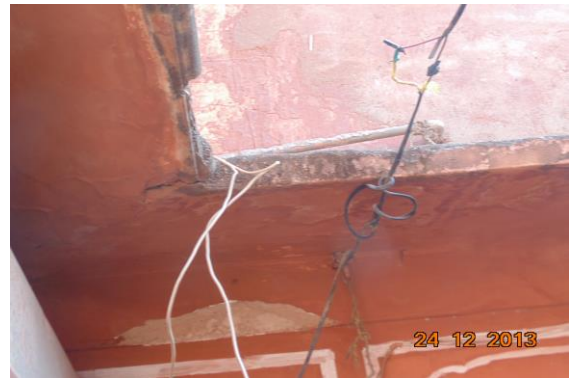
Photo 38

Damaged Portion on Wall No. 2, 4 & Shade of Open Sky of First Floor

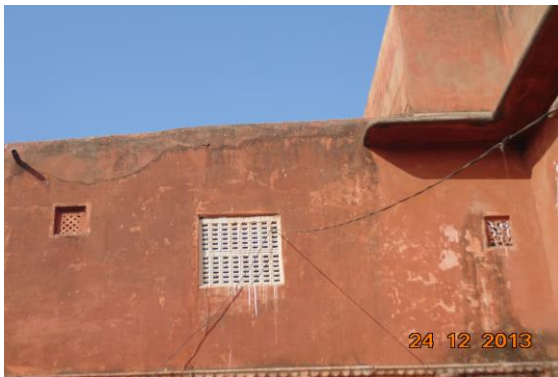
Photo 39

Dampness/Seepage on Wall No. 1 of Open Sky of First Floor

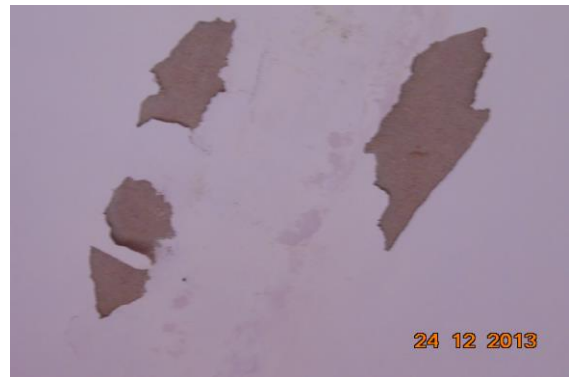
Photo 40

Dampness/Seepage on Roof of Varanda of First Floor

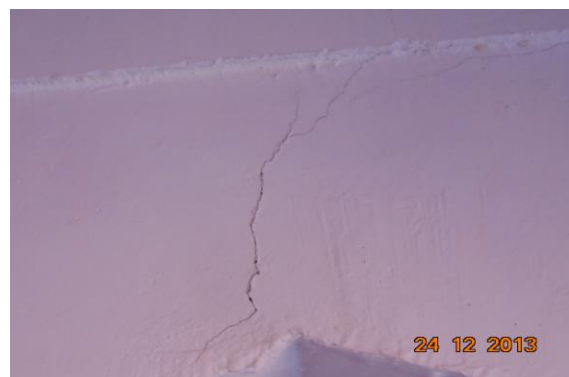
Photo 42

Peeling of Plaster on Wall No. 2 of Varanda of First Floor

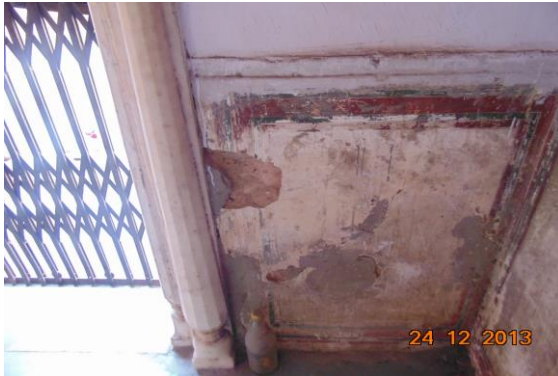
Photo 43
Peeling of Plaster on Wall No. 3 of Varanda of First Floor

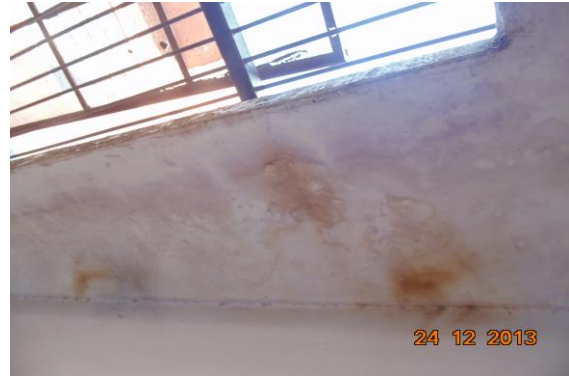
Photo 44
Dampness/Seepage on Wall No. 4 & Shade of Open Sky of First Floor

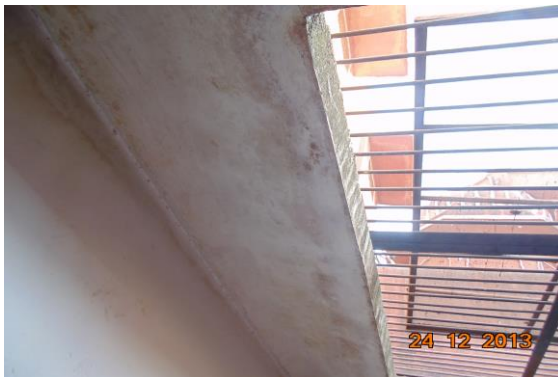
Photo 45
Dampness/Seepage on Wall No. 1 of Open Sky of First Floor

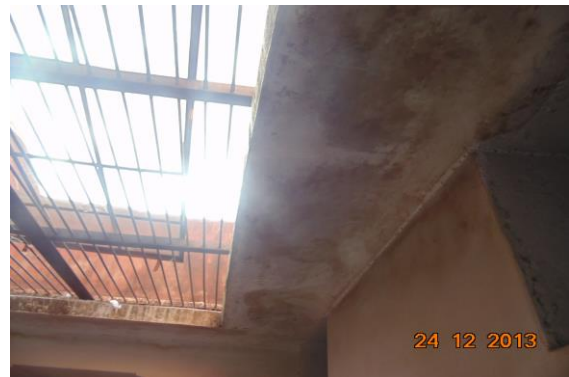
Photo 46
Dampness/Seepage on Wall No. 3 of Open Sky of First Floor

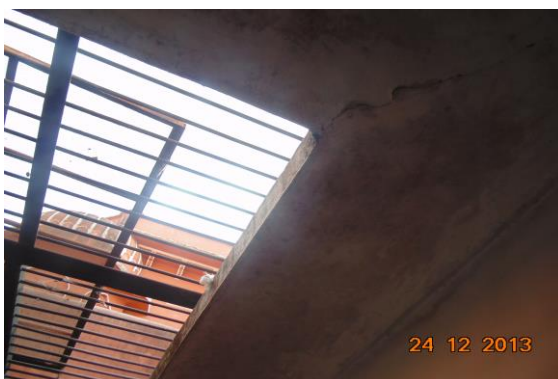
Photo 47
Dampness/Seepage on Wall No. 2 of Open Sky of First Floor

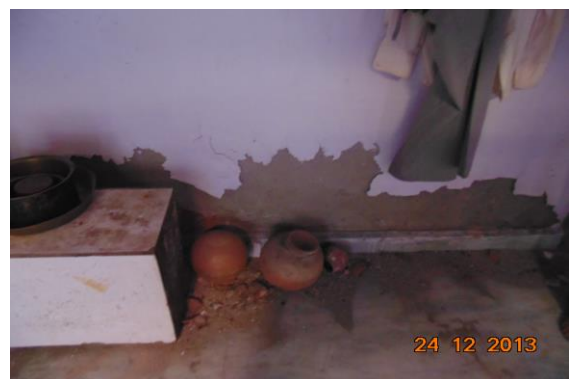
Photo 48
Peeling of Plaster on Wall No. 4 of Kitchen of First Floor

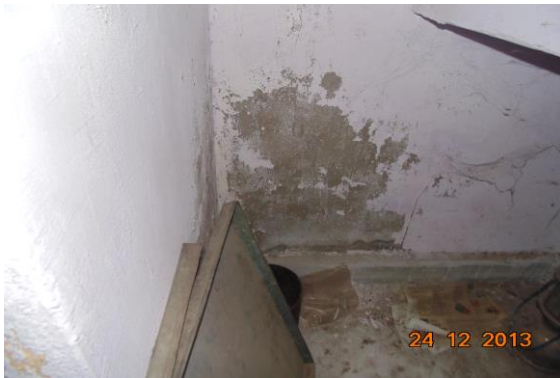
Photo 49
Peeling of Plaster on Wall No. 1 of Gallery No.2 of First Floor

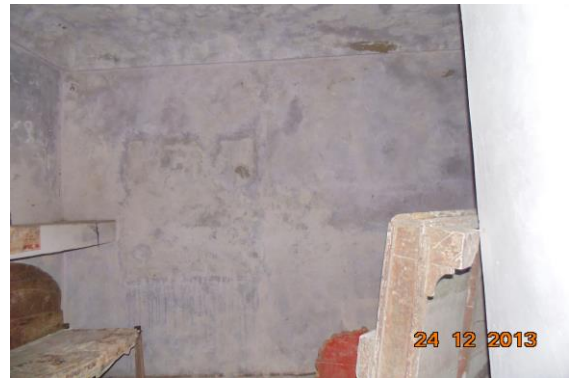
Photo 50
Dampness/Seepage on Wall No. 4 of Gallery No.3 of First Floor

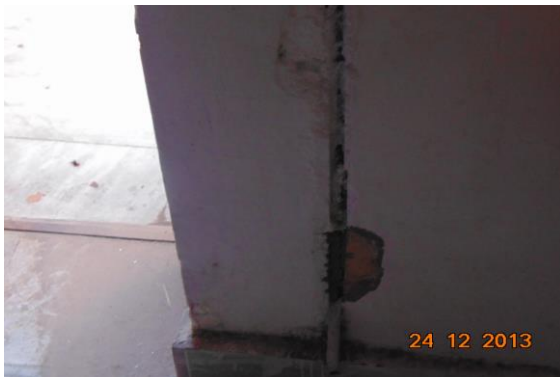
Photo 51
Peeling of Plaster on Wall No. 3 of Kitchen of First Floor
