Pre Building Condition Survey Report

Name and Address of Structure :	Badi Chopar Station Area
---------------------------------	--------------------------

Name of the Project	Contract JMRC-UG1B “Design and Construction of Tunnel between Chandpole and Badi Chouper and reverse line by Shield TBM, Underground Metro Stations at Choti Chouper and Badi Chouper by Cut and Cover Methods on East West Corridor of Jaipur Metro Rail Corporation Limited .”	
Owner :

Pre - Condition Building Survey for Construction of Underground Stations from Chandpole to Bari Chouper and reversal line

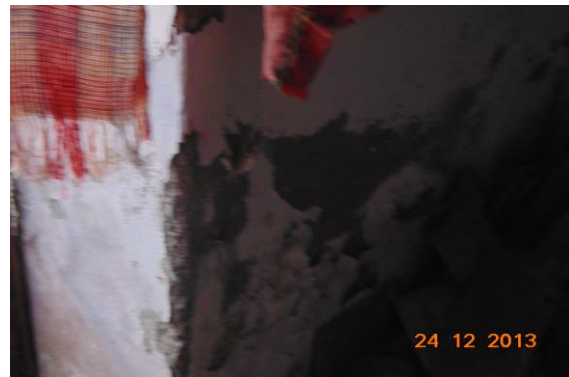
Photo 52
Peeling of Plaster on Wall No. 3 of Kitchen of First Floor

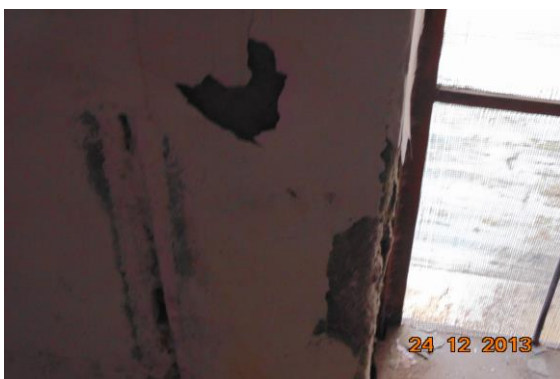
Photo 53
Peeling of Plaster on Wall No. 3 of Kitchen of First Floor

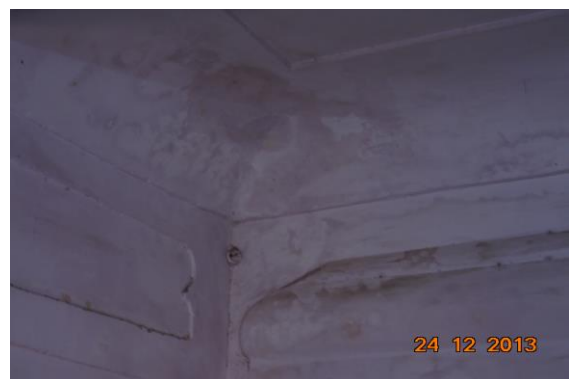
Photo 54
Dampness/Seepage on Wall No. 1, 4 & Roof of Room No. 1 of Temple Shri Chandra Vihari Ji, First Floor

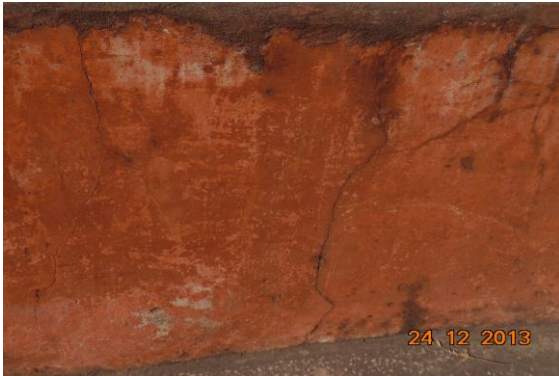
Photo 55
Peeling of Plaster on Parapet Wall of Second Floor

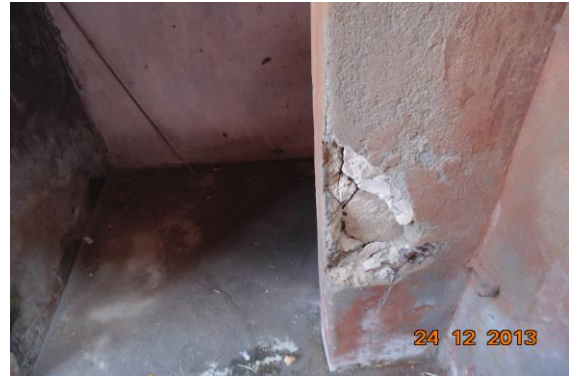
Photo 56
Damaged Portion on Outer Wall No.3 of Toilet & Washroom of Third Floor

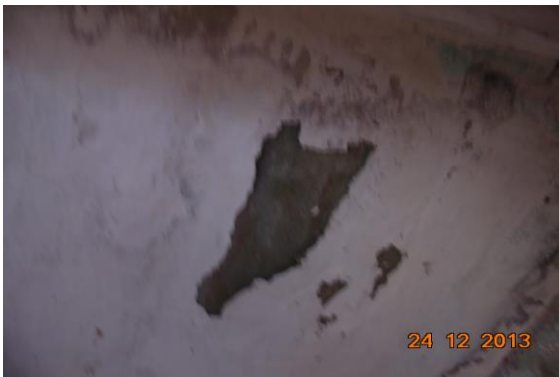
Photo 57
Dampness/Seepage on Roof of Toilet & Washroom of Third Floor

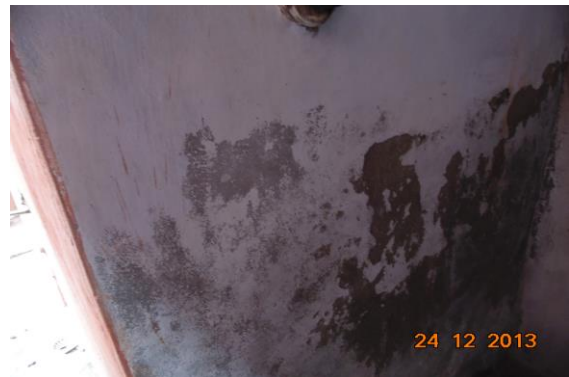
Photo 58
Dampness/Seepage on Wall No. 1 of Toilet & Washroom of Third Floor

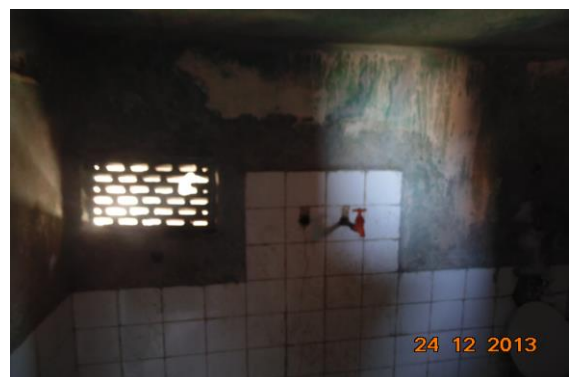
Photo 60
Dampness/Seepage on Wall No. 4 of Toilet & Washroom of Third Floor

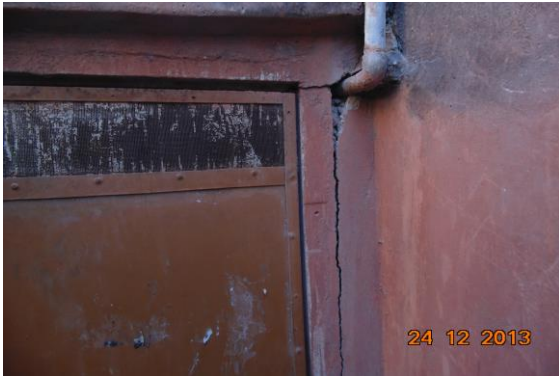
Photo 61

Damaged Portion on Outer Wall No.3 of Toilet No. 2 of Third Floor

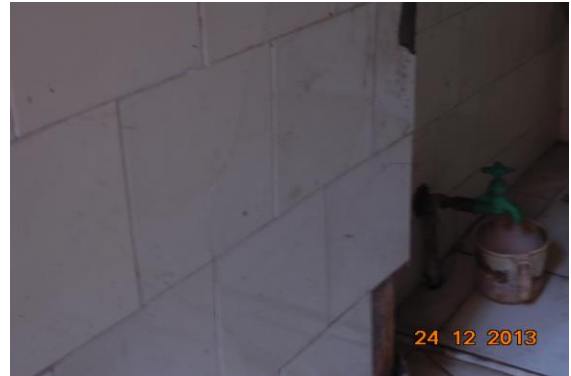
Photo 62

Damaged Portion on Wall No. 1 of Toilet No. 2 of Third Floor

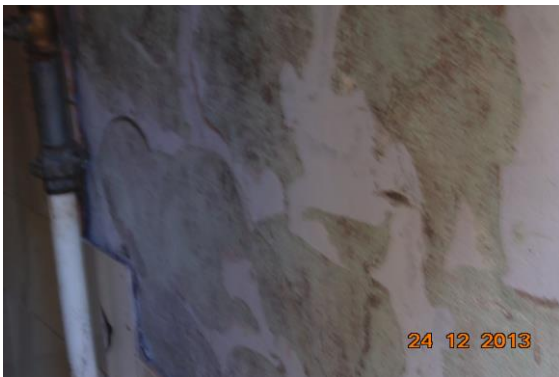
Photo 63

Damaged Portion on Wall No. 2 of Toilet No. 2 of Third Floor

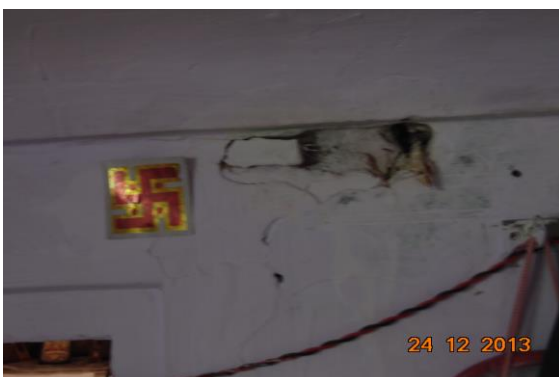
Photo 65

Peeling of Plaster on Wall No. 2 of Room No. 4 of Third Floor

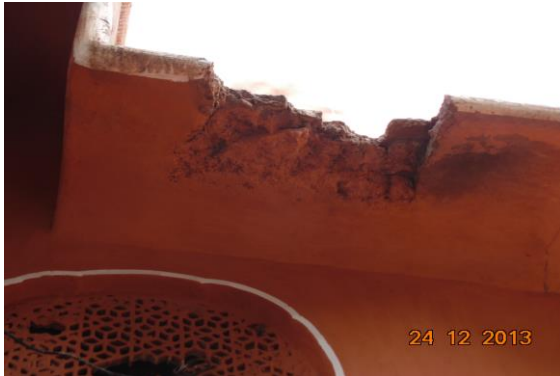
Photo 67

Peeling of Plaster on Floor Tiles of Varanda of Shop Ground Floor

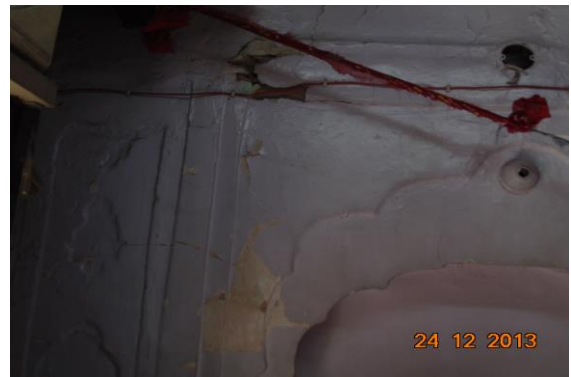
Photo 70

Dampness/Seepage on Wall No. 1 of Part A of Sharma Odhani Palace of First Floor

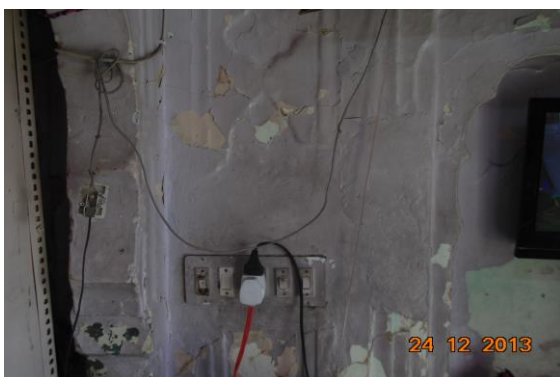
Photo 71

Dampness/Seepage on Wall No. 2 of Part A of Sharma Odhani Palace of First Floor

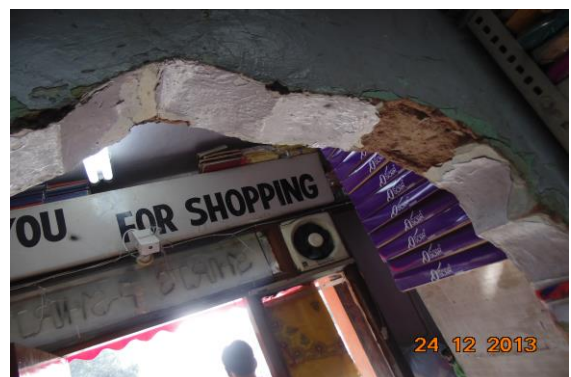
Photo 72

Peeling of Plaster on Roof of Part B of Sharma Odhani Palace of First Floor

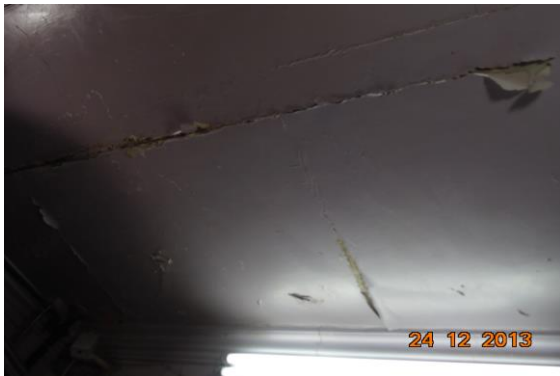
Photo 73

Dampness/Seepage on Roof of Part D of Sharma Odhani Palace of First Floor

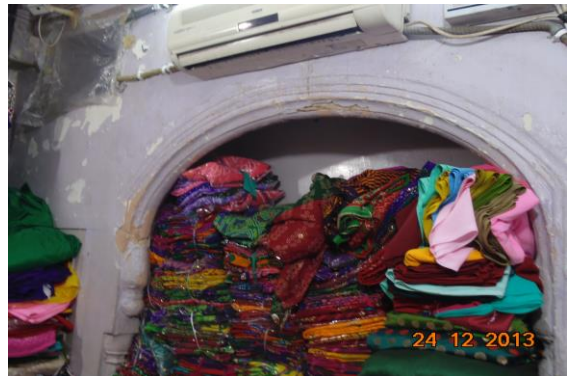
Photo 74

Peeling of Plaster on Wall No. 2 of Part D of Sharma Odhani Palace of First Floor

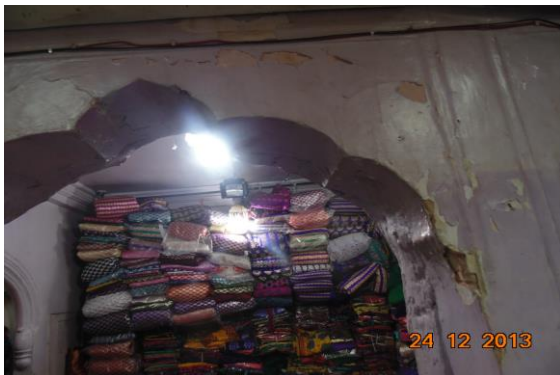
Photo 75

Peeling of Plaster on Outer Wall No.3 of Part D of Sharma Odhani Palace of First Floor

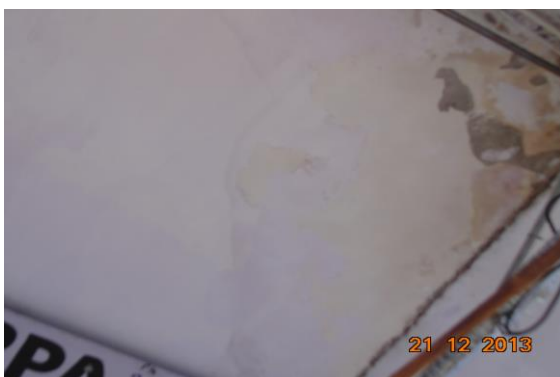
Photo 77

Dampness/Seepage on Roof of Varanda of shop of Ground Floor

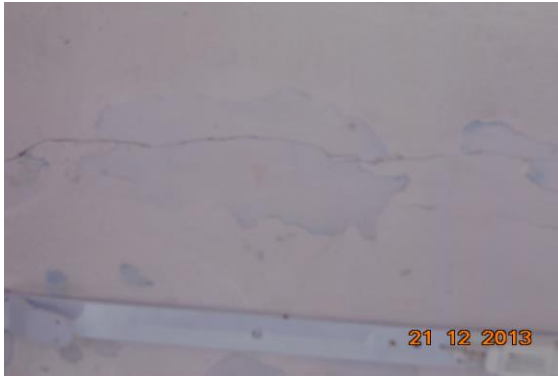
Photo 79

Peeling of Plaster on Roof of Varanda of shop of Ground Floor

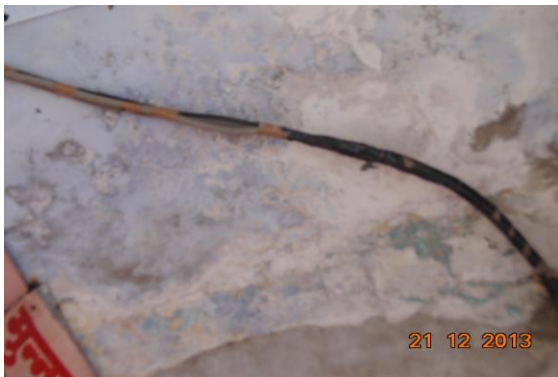
Photo 80

Peeling of Plaster on Floor Tiles of Varanda of shop of Ground Floor

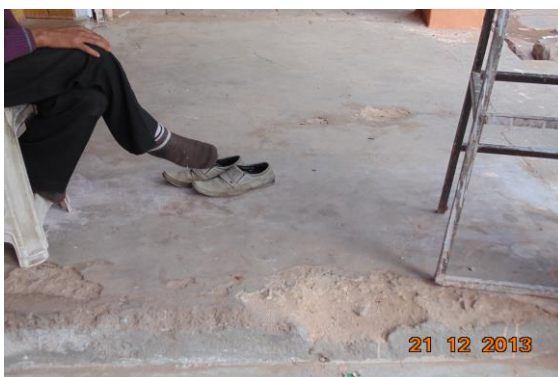
Photo 82

Peeling of Plaster on Roof of Varanda of shop of Ground Floor

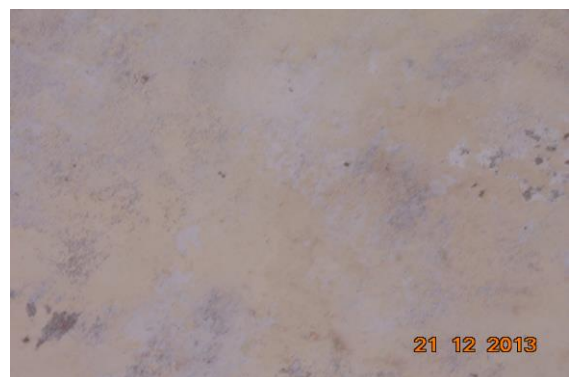
Photo 83

Peeling of Plaster on Floor of Varanda of shop of Ground Floor

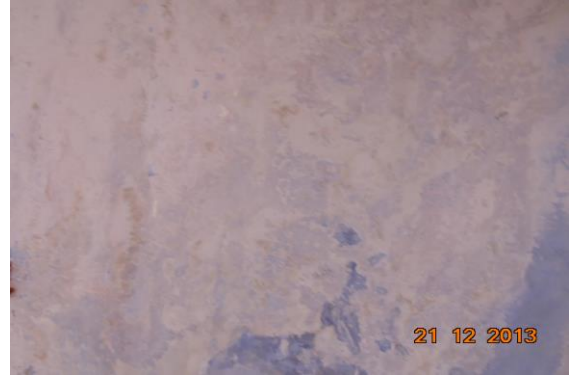
Photo 85

Peeling of Plaster on roof of Varanda of shop of Ground Floor

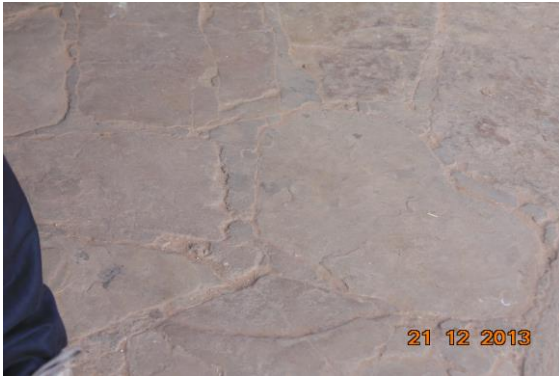
Photo 86

Dampness/Seepage on Roof of Varanda of shop of Ground Floor

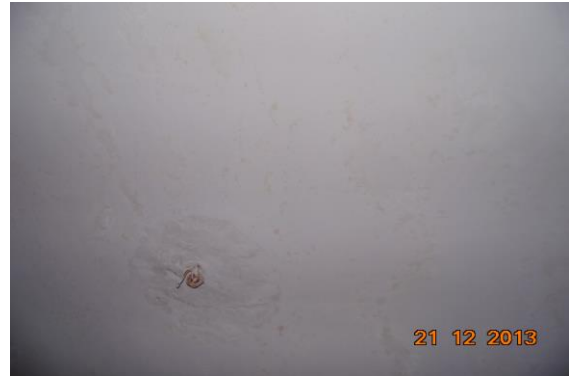
Photo 87

Peeling of Plaster on Floor of Varanda of shop of Ground Floor

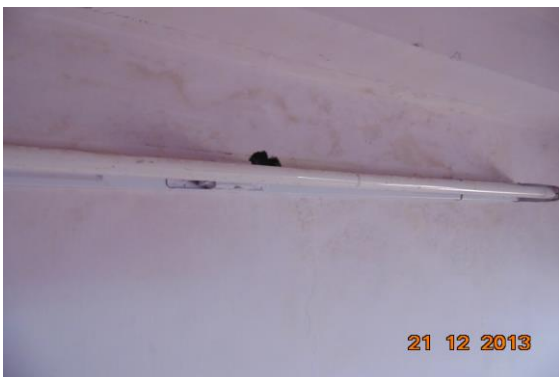
Photo 88

Dampness/Seepage on Roof of Shop no.6 of Upper ground Floor

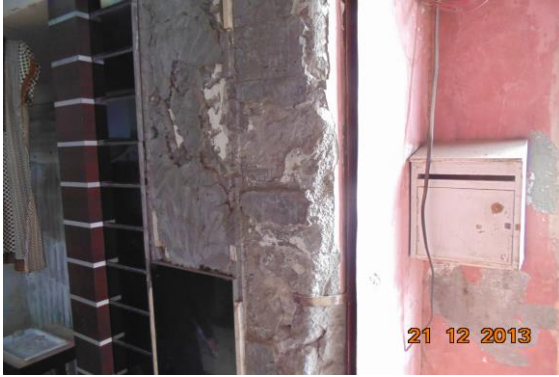
Photo 90

Dampness/Seepage on Front side Roof of Shop no.6 of Ground Floor

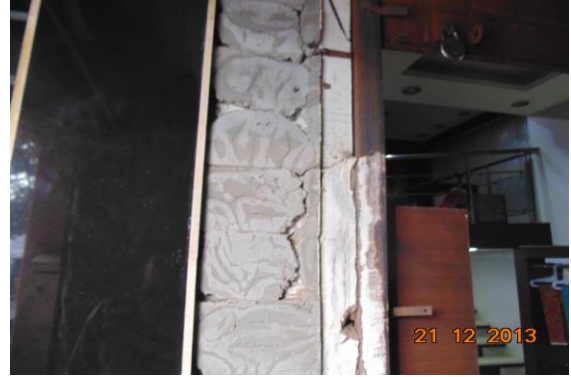
Photo 91

Peeling of Plaster on Right side Wall of Shop No.7 of Ground Floor

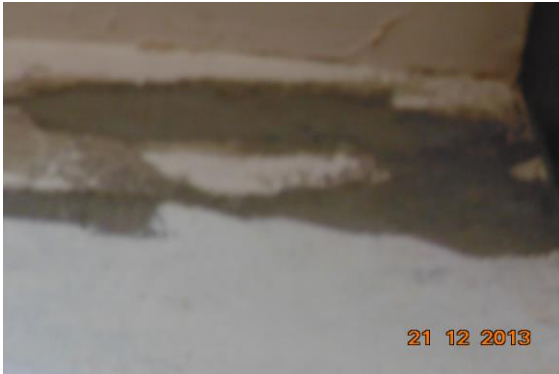
Photo 92

Peeling of Plaster on Left side Wall of Varanda of shop of Ground Floor

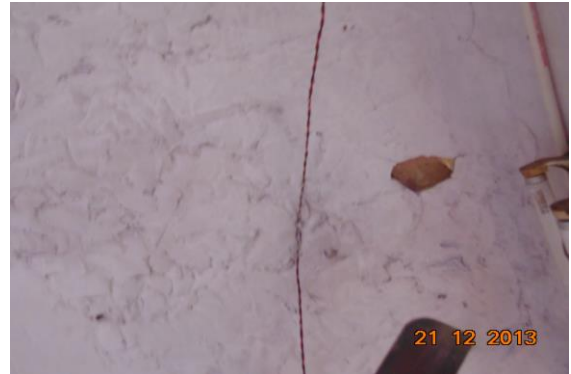
Photo 93

Peeling of Plaster on Wall No. 4 of Varanda of shop of Ground Floor

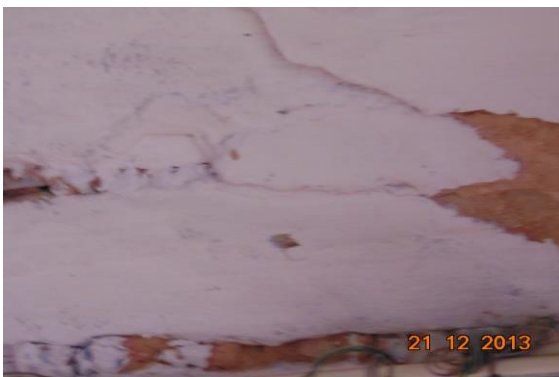
Photo 94

Peeling of Plaster on Roof of Varanda of shop of Ground Floor

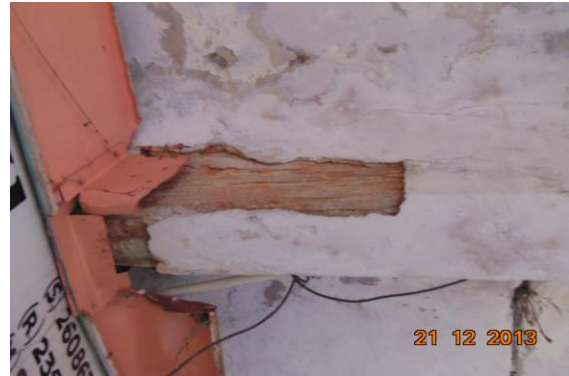
Photo 97

Dampness/Seepage on Roof of Varanda of shop of Ground Floor

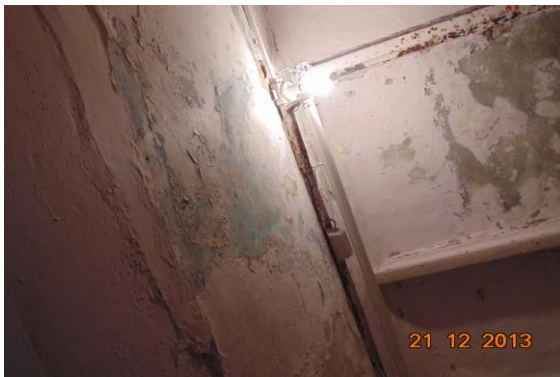
Photo 98

Peeling of Plaster on Roof of Varanda of shop of Ground Floor

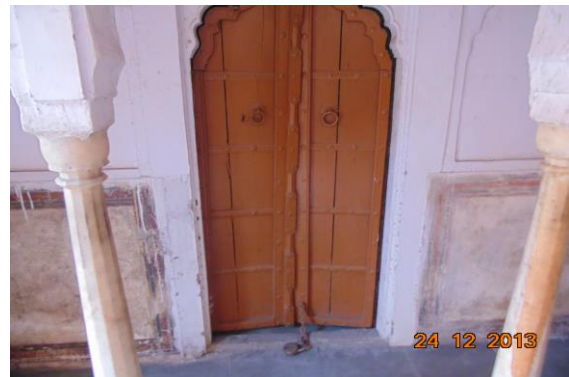
Photo 99

Dampness/Seepage on Wall No. 1 & Roof of Shop No.11 of Upper ground Floor

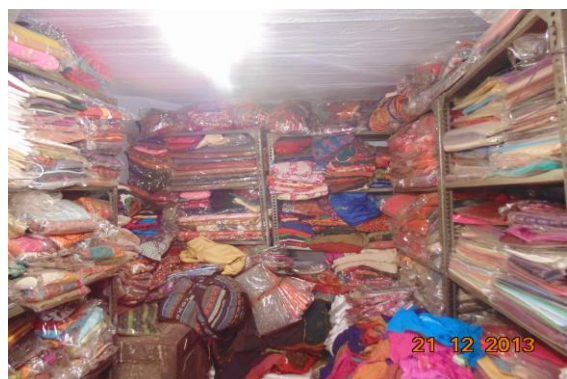
Photo 120

All Walls of Mota roopa Enterprises of Basement Covered with Material

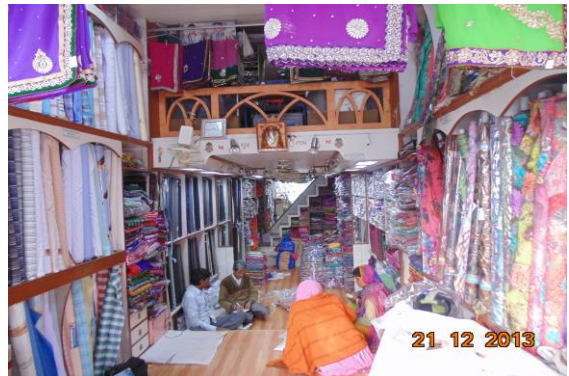
Photo 122

All Walls of Shop No.3 of Ground Floor Covered with Clothes

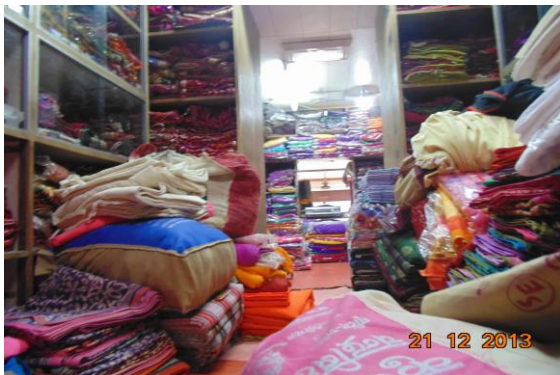
Photo 123

All Walls of Shop No.3 of Upper ground Floor Covered with Clothes

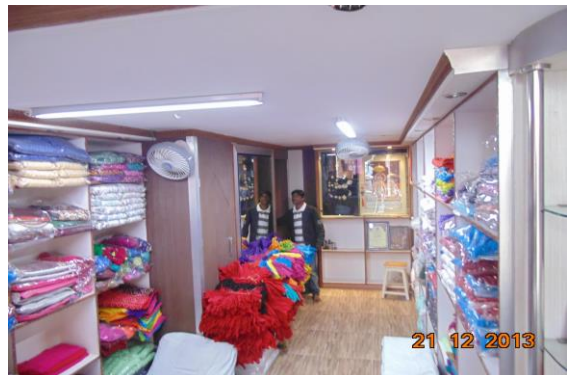
Photo 124

All Walls of Shop No.4 of Lower ground Floor Covered with Clothes & wooden racks

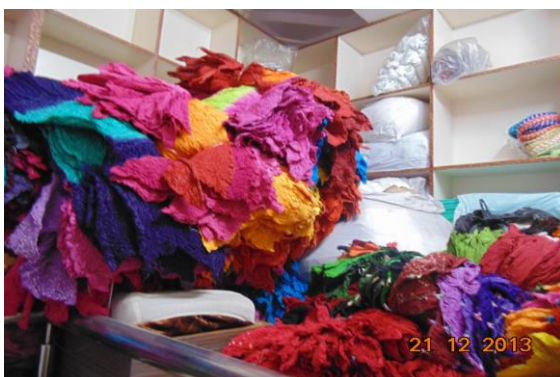
Photo 125

All Walls of Shop No.4 of Upper ground Floor Covered with Clothes & wooden racks

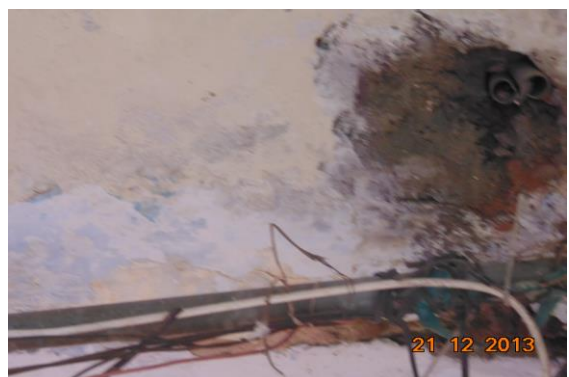
Photo 126

All Walls of Part a Shop no.5 of Ground Floor Covered with wooden racks & Material

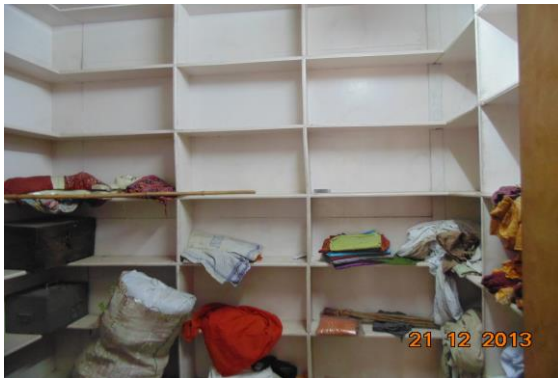
Photo 127

All Walls of Part B Shop no.5 of Ground Floor Covered with wooden racks & Material

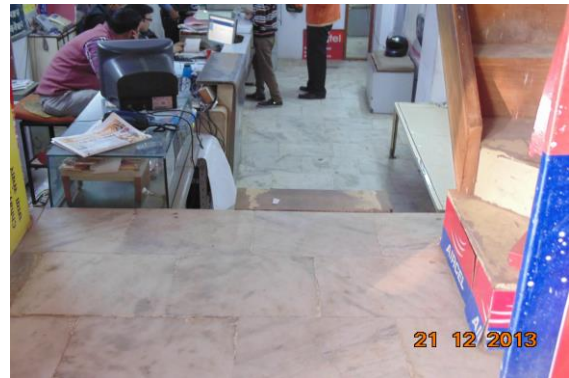
Photo 128

All Walls of Shop no.6 of Lower ground Floor Covered with Marbels

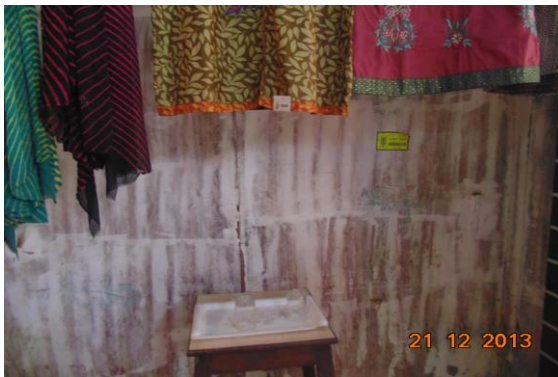
Photo 129

Wall No. 2 of Varanda of shop of Ground Floor

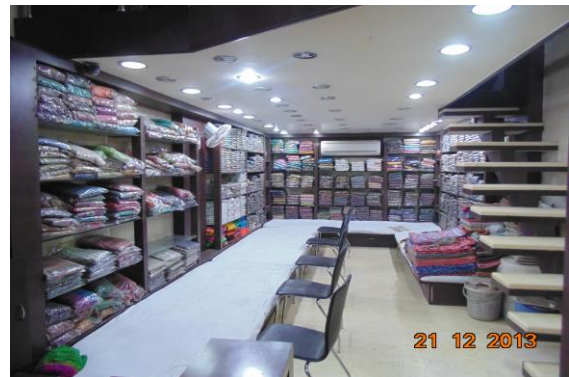
Photo 130

All Walls of Shop No.7 of Lower ground Floor Covered with wooden racks & clothes

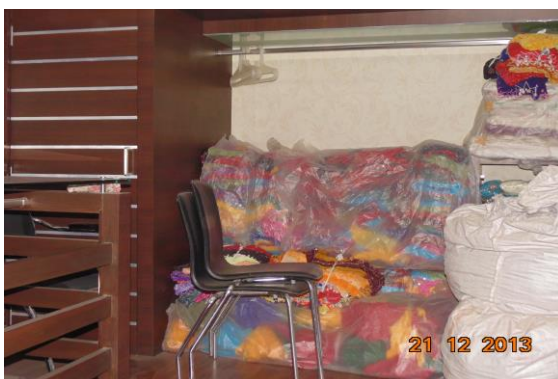
Photo 131

All Walls of Shop No.7 of Upper ground Floor Covered with wooden racks & clothes

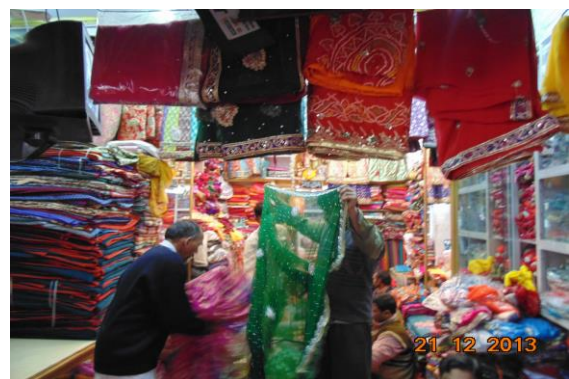
Photo 132

All Walls of Shop No.9 of Ground Floor Covered with wooden racks & clothes

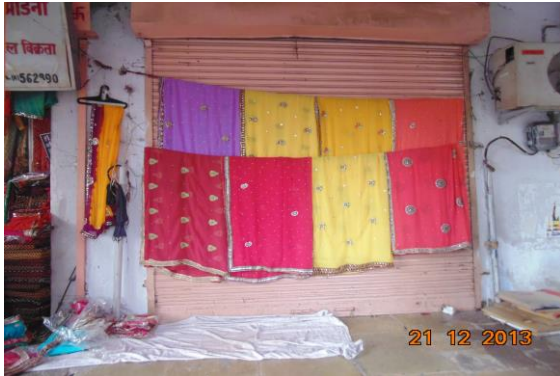
Photo 133
Shop No.10 of Ground Floor Locked

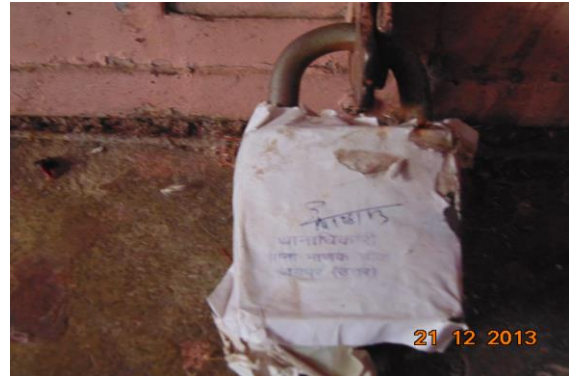
Photo 134
Shop No.10 of Ground Floor Locked

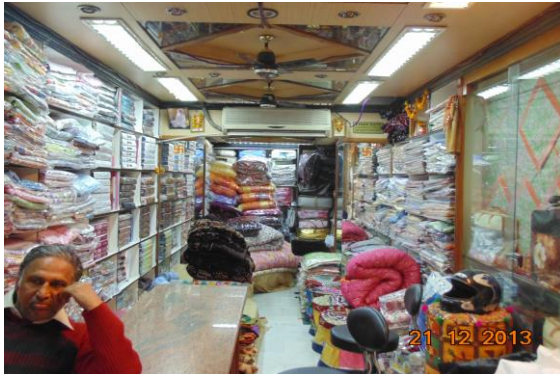
Photo 135
All Walls of Shop No.11 of Lower ground Floor Covered with wooden racks & Material

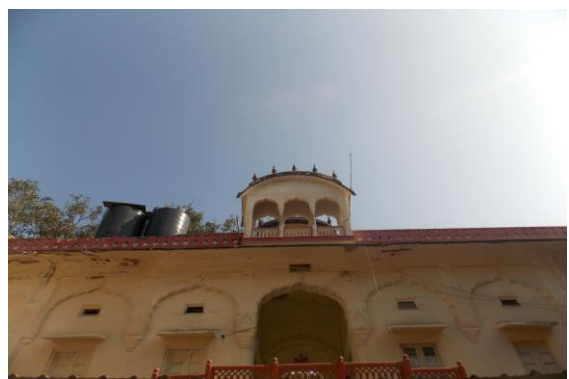
Photo 24
View of Temple Anand Bihari Ji frontside, Ground Floor

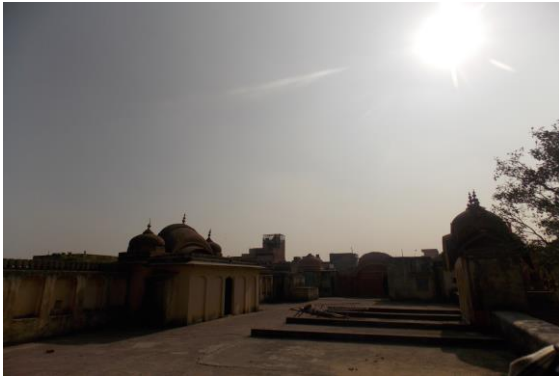
Photo 25
View of Terrace, Terrace

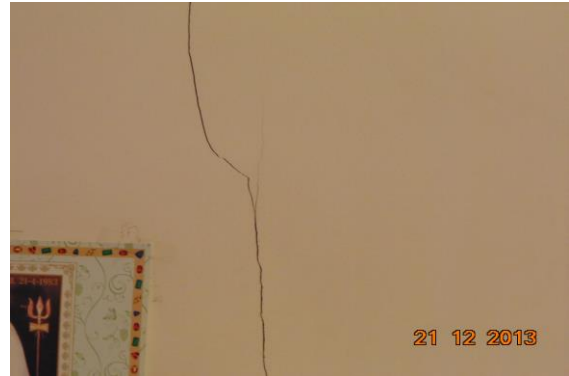
Photo 26
Horizontal Crack on Wall No. 2 of Shop no.20, Ground floor
Approx. Width = 2mm, Approx. Length = 3m.
Distance from Wall no.3 = 2m, Height from Floor = 0m.

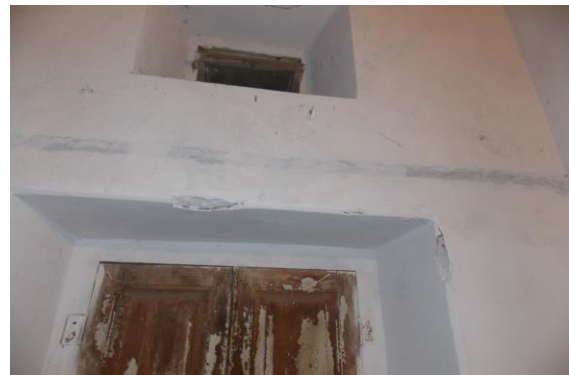
Photo 27
Horizontal Crack on Roof of Varanda No.3, Second Floor
Approx. Width = 3mm, Approx. Length = 1.3m.
Distance from Wall No.3 = 0.02m, Height from Floor = 3.3m.

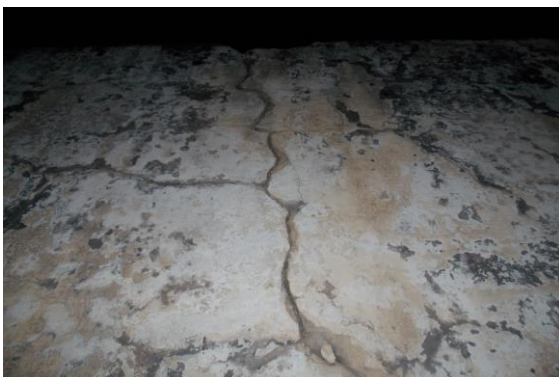
Photo 28
Inclined Crack on Wall No. 4 of Open Varanda No.2, Second Floor
Approx. Width = 5mm, Approx. Length = 1.2m.
Distance from Wall No.1 = 2.2m, Height from Floor = 1.3m.

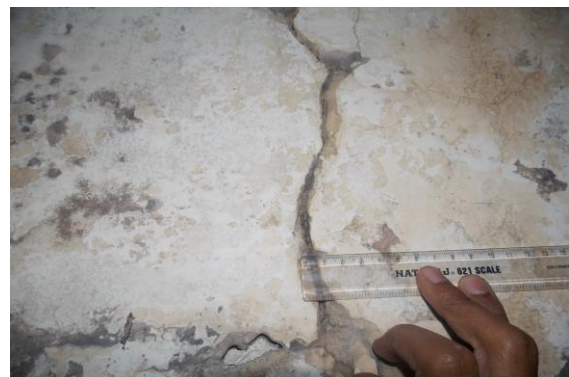
Photo 28A
Inclined Crack on Wall No. 4 of Open Varanda No.2, Second Floor
Approx. Width = 5mm, Approx. Length = 1.2m.
Distance from Wall No.1 = 2.2m, Height from Floor = 1.3m.

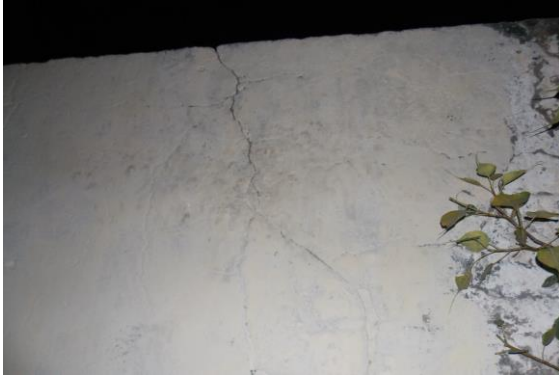
Photo 29

Inclined Crack on Wall No. 4 of Open Varanda No.2, Second Floor
Approx. Width = 4mm, Approx. Length = 2.1m.
Distance from Wall No.1 = 0.15m, Height from Floor = 1.3m.

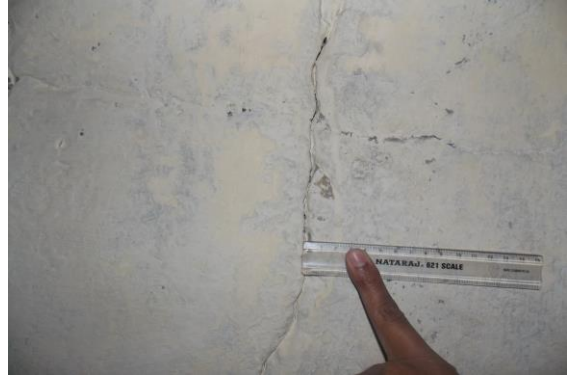
Photo 29A

Inclined Crack on Wall No. 4 of Open Varanda No.2, Second Floor
Approx. Width = 4mm, Approx. Length = 2.1m.
Distance from Wall No.1 = 0.15m, Height from Floor = 1.3m.

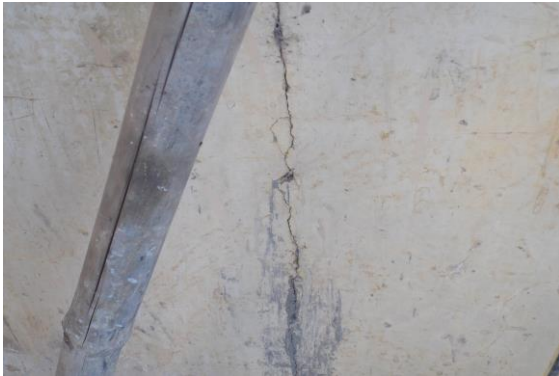
Photo 30

Vertical Crack on Wall No. 4 of Open Sky, Temple Shri Anand Bihari Ji, First Floor Approx. Width = 2mm, Approx. Length = 1.1m. Distance from Wall No.1 = 4.5m, Height from Floor = 0m.

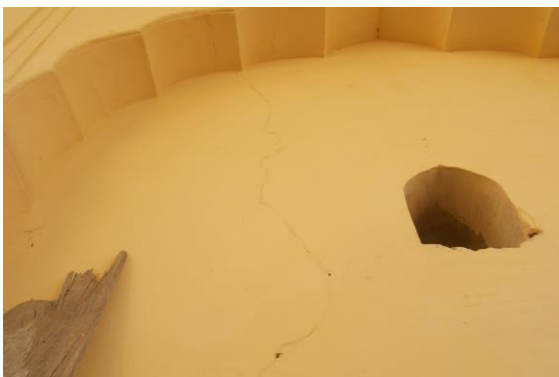
Photo 31

Inclined Crack on Wall No. 4 of Open Sky, Temple Shri Anand Bihari Ji, First Floor Approx. Width = 1mm, Approx. Length = 2.5m. Distance from Wall No.1 = 3.8m, Height from Floor = 2.1m.

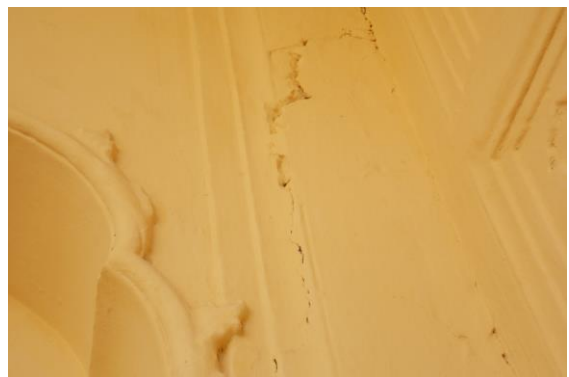
Photo 32

Inclined Crack on Wall No. 4 of Open Sky, Temple Shri Anand Bihari Ji, First Floor Approx. Width = 3mm, Approx. Length = 1.6m. Distance from Wall No.2 = 0.25m, Height from Floor = 2.3m.

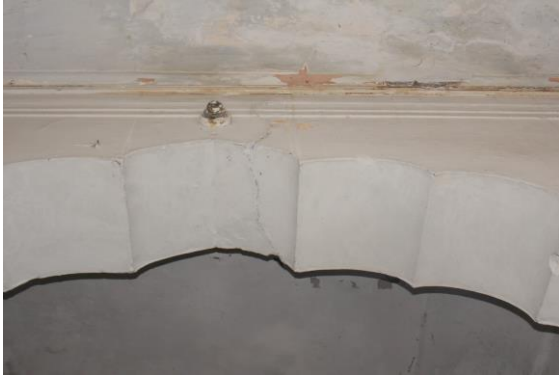
Photo 33

Inclined Crack on External Gate Area of Hall No. 4, Temple Shri Anand Bihari Ji, First Floor Approx. Width = 2mm, Approx. Length = 0.8m.
Distance from Wall No.1 = 1.3m, Height from Floor = 3.5m.

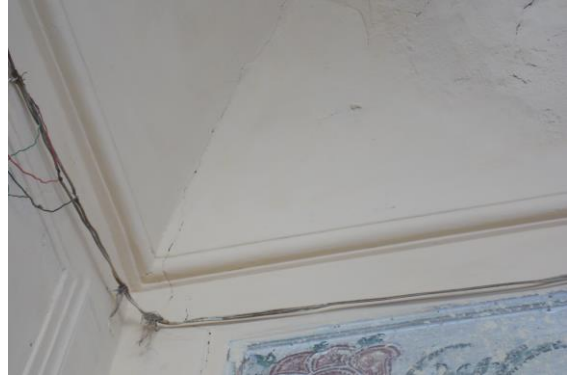
Photo 34

Inclined Crack on Roof & Wall No. 4 of Varanda No.1, First Floor Approx. Width = 0.35mm, Approx. Length = 1.2m.
Distance from Wall No.4 = 0.2m, Height from Floor = 3m.

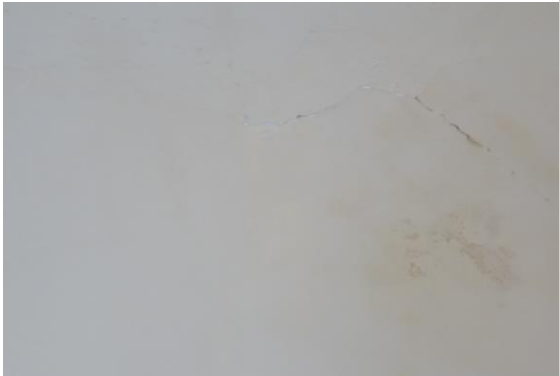
Photo 35

Inclined Crack on Roof of Varanda No.1, First Floor Approx. Width = 0.5mm, Approx. Length = 2.5m.
Distance from Wall No.2 = 0.4m, Height from Floor = 4m.

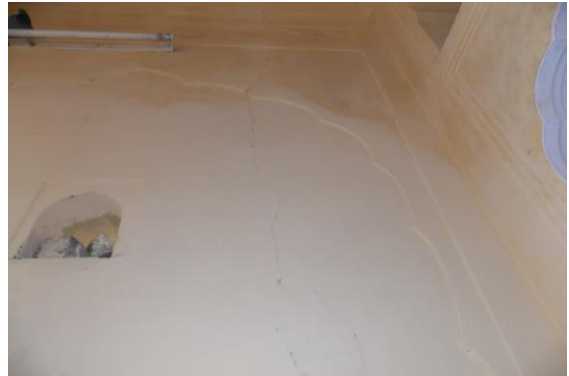
Photo 36

Inclined Crack on Wall No. 1 of Passage No.1, First Floor Approx. Width = 2mm, Approx. Length = 2.3m.
Distance from Wall No.4 = 0.45m, Height from Floor = 2.1m.

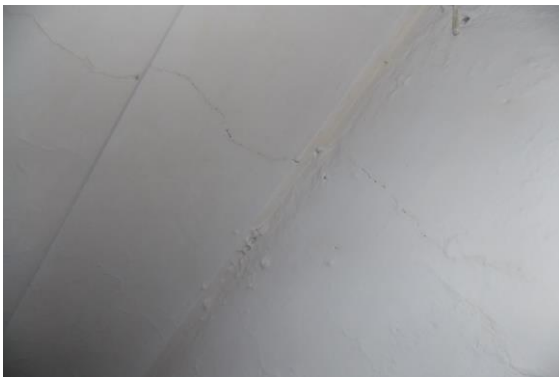
Photo 37

Inclined Crack on Wall No. 2 & Roof of Passage No.2, First Floor Approx. Width = 0.5mm, Approx. Length = 1.2m.
Distance from Wall no.3 = 0.25m, Height from Floor = 2.1m.

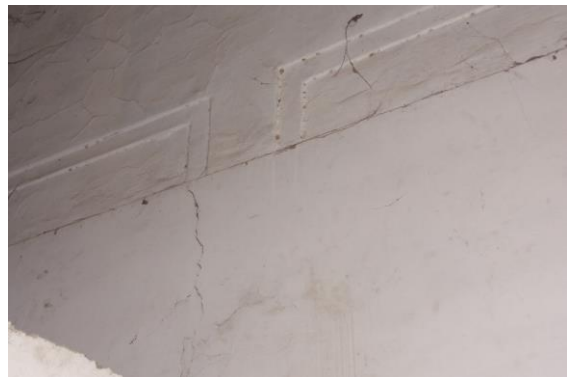
Photo 38

Inclined Crack on Wall No. 4 of Varanda No.1, First Floor Approx. Width = 1mm, Approx. Length = 0.3m.
Distance from Wall No.1 = 2m, Height from Floor = 2.2m.

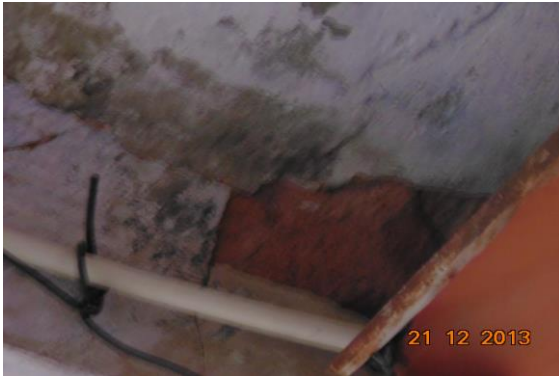
Photo 39
Peeling of Plaster on Roof of Varanda of shop of Ground Floor

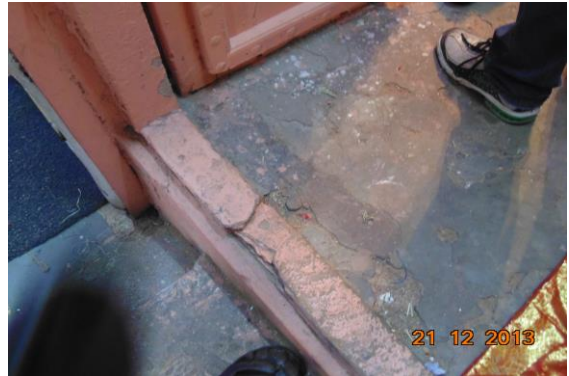
Photo 40
Peeling of Plaster on Floor of Part A of shop no.13 of Ground Floor

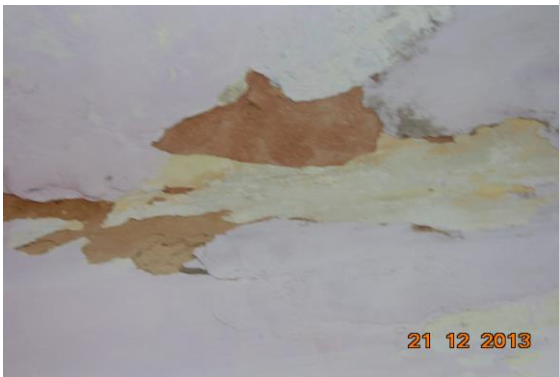
Photo 41
Peeling of Plaster on Roof of Part A of shop no.13 of Ground Floor

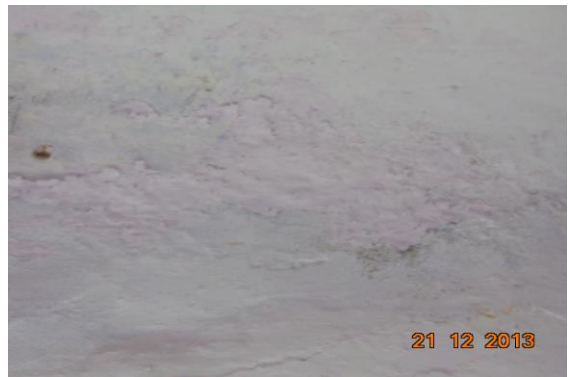
Photo 42
Dampness/Seepage on Roof of Part A of shop no.13 of Ground Floor

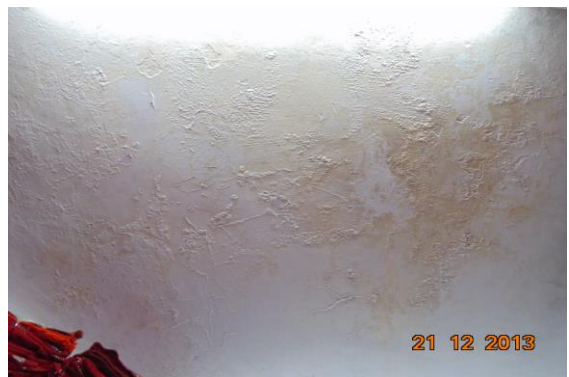
Photo 44
Dampness/Seepage on Roof of Part c of shop no.12 of Ground Floor

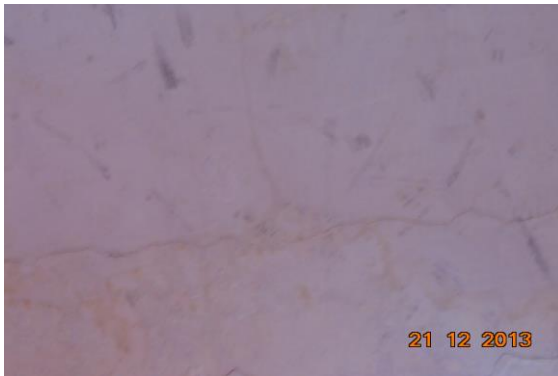
Photo 45
Peeling of Plaster on Beam of Part c of shop no.12 of Ground Floor

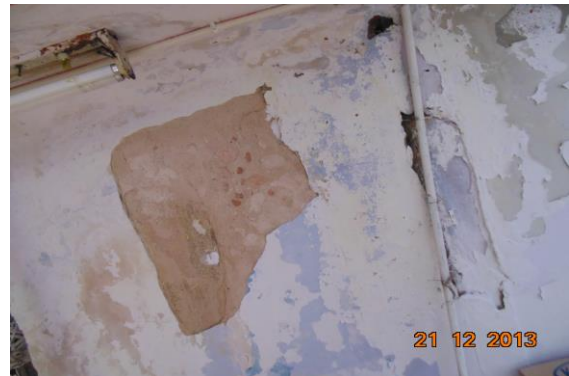
Photo 46
Dampness/Seepage on of varanda of shop of Ground Floor

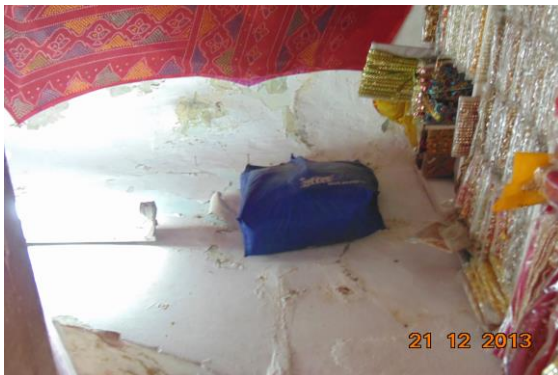
Photo 47
Dampness/Seepage on Wall No. 2 & Roof of Shop no.14 of Upper ground Floor

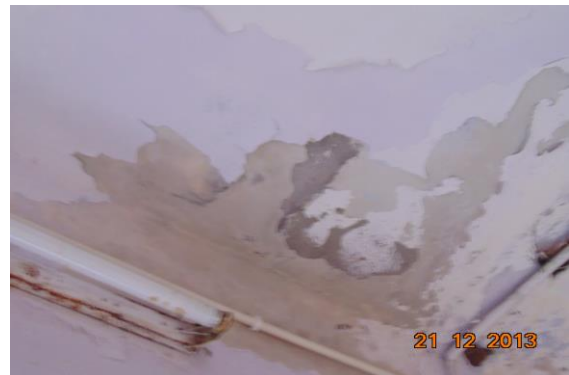
Photo 48
Dampness/Seepage on Roof of Varanda of shop of Ground Floor

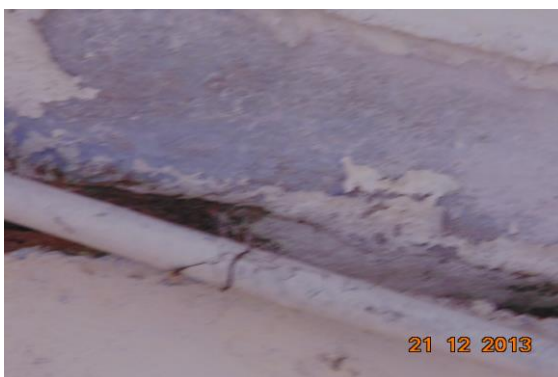
Photo 49
Peeling of Plaster on Roof of Varanda of shop of Ground Floor

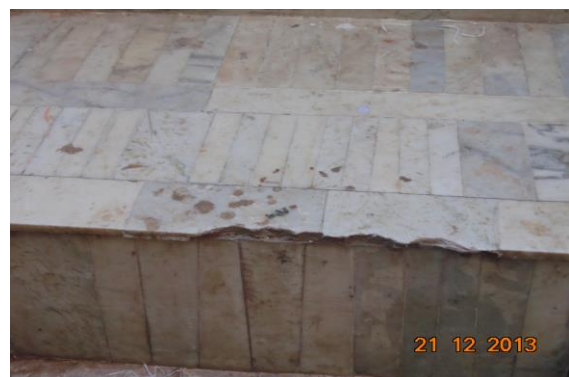
Photo 50
Peeling of Plaster on Floor of Varanda of shop of Ground Floor

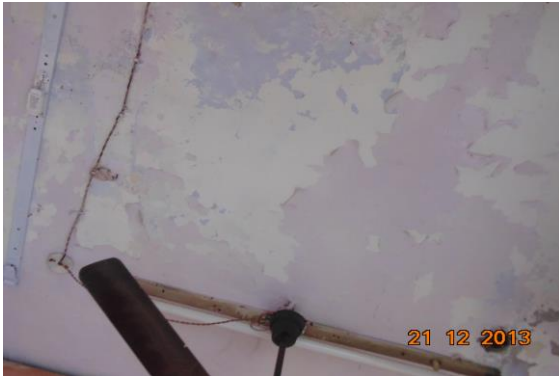
Photo 51
Dampness/Seepage on Roof of Varanda of shop of Ground Floor

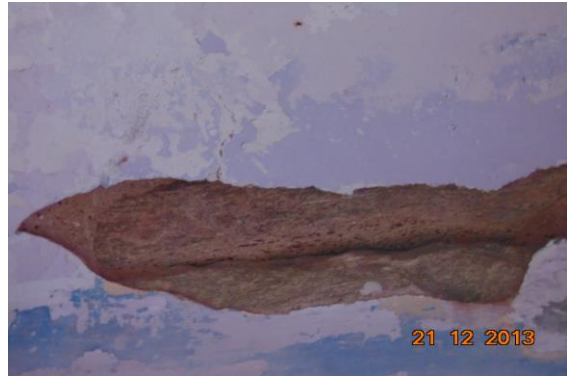
Photo 52
Peeling of Plaster on Roof of Varanda of shop of Ground Floor

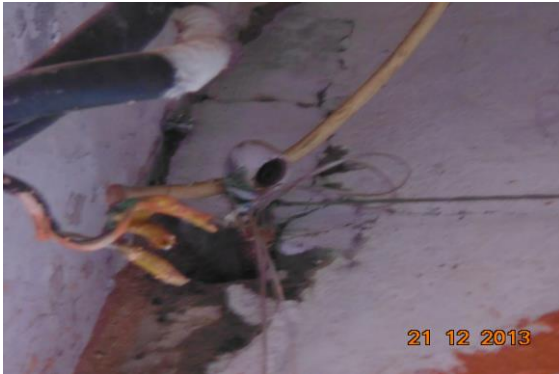
Photo 53
Peeling of Plaster on Right side External column of Varanda of shop of Ground Floor

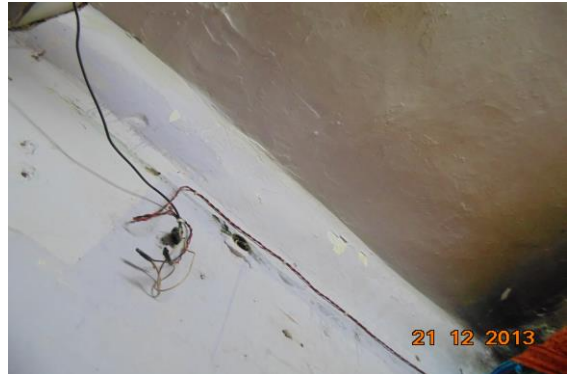
Photo 54
Dampness/Seepage on Wall No. 1 & Roof of Shop No.16 of Upper ground Floor

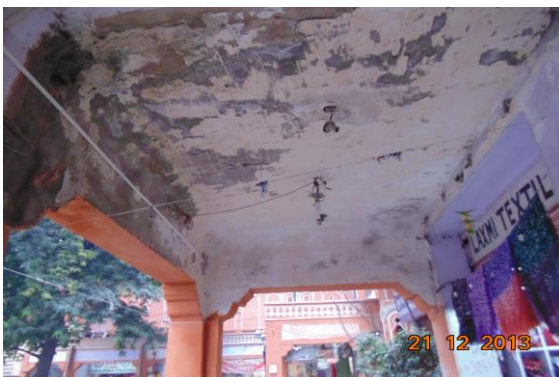
Photo 55
Dampness/Seepage on Roof of Varanda of shop of Ground Floor

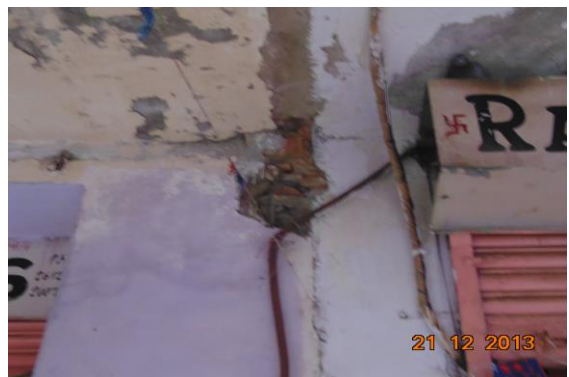
Photo 56
Peeling of Plaster on Frontside Wall No.3 of Shop No.17 of Ground Floor

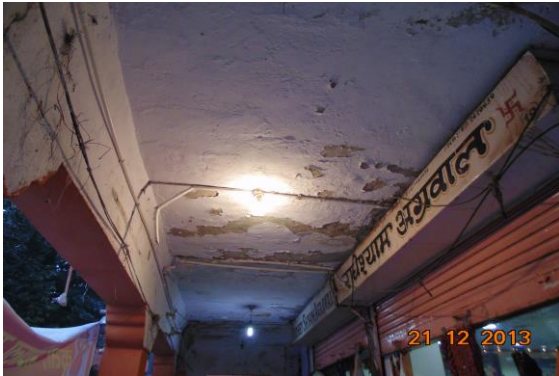
Photo 57
Dampness/Seepage on the roof of the Varanda of a shop on the ground floor

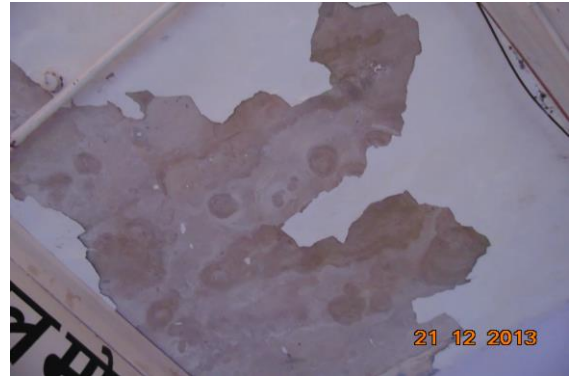
Photo 58
Peeling of Plaster on Roof of Varanda of Shop of Ground floor

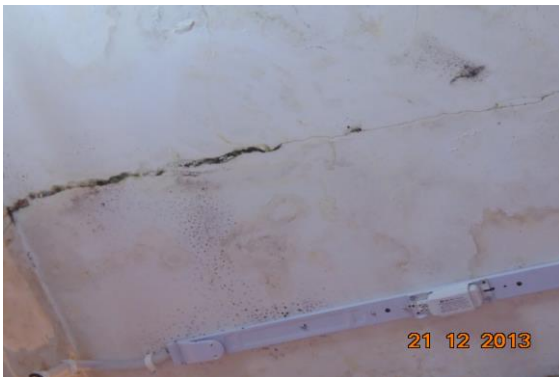
Photo 59
Peeling of Plaster on Roof of Varanda of Shop of Ground floor

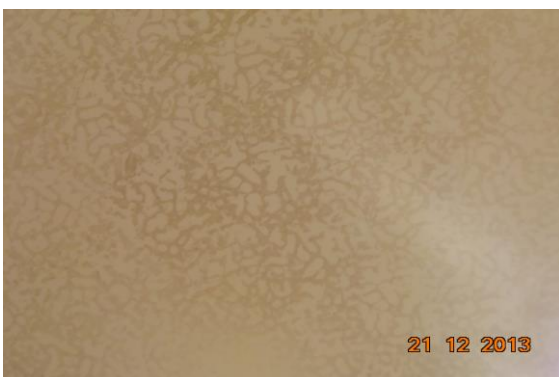
Photo 61
Dampness/Seepage on Roof of Shop no.20 of Ground floor

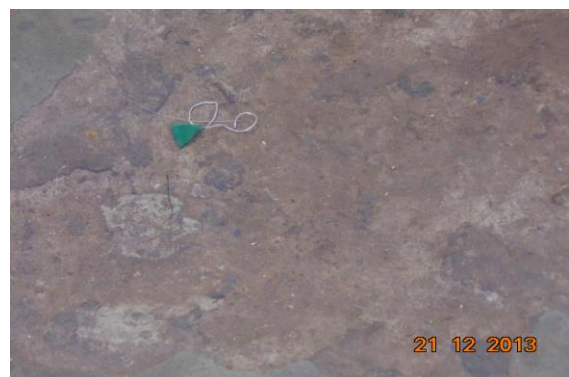
Photo 62
Peeling of Plaster on Floor of Varanda of shop of Ground floor

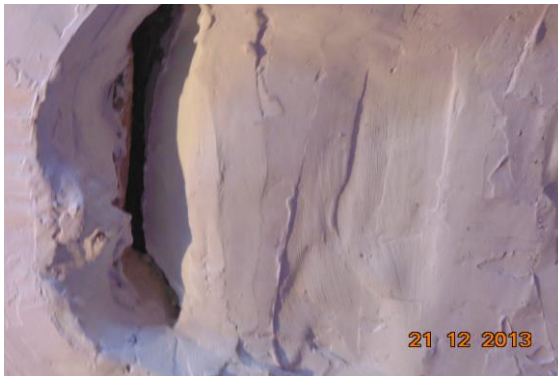
Photo 63

Peeling of Plaster on Roof of Varanda of shop of Ground floor

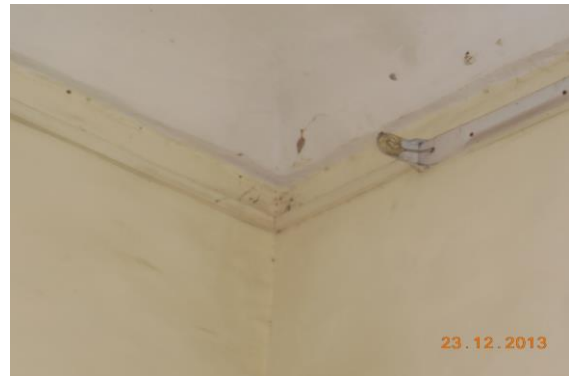
Photo 64

Dampness/Seepage on Roof of Hall No. 1 of Ground Floor

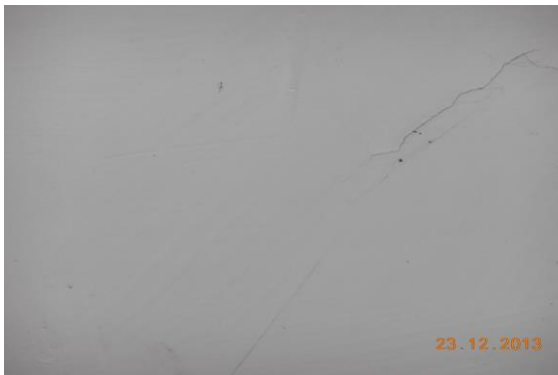
Photo 65

Peeling of Plaster on Roof of Hall No. 2 of Ground Floor

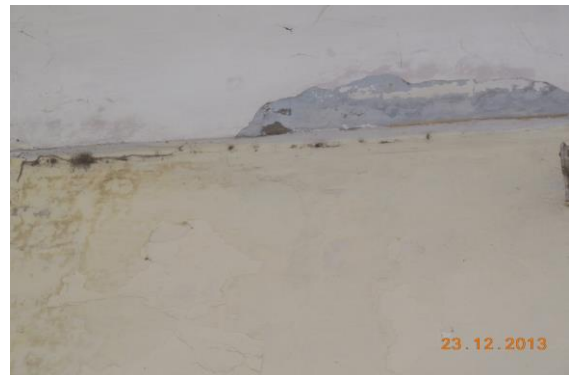
Photo 66

Dampness/Seepage on Wall No. 4 of Main Gate of Ground Floor

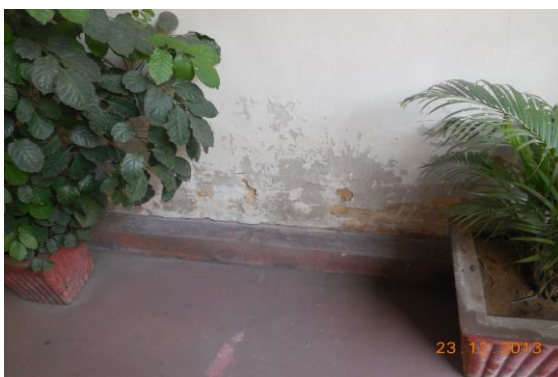
Photo 67

Peeling of Plaster on Wall No. 1 of Main Gate of Ground Floor

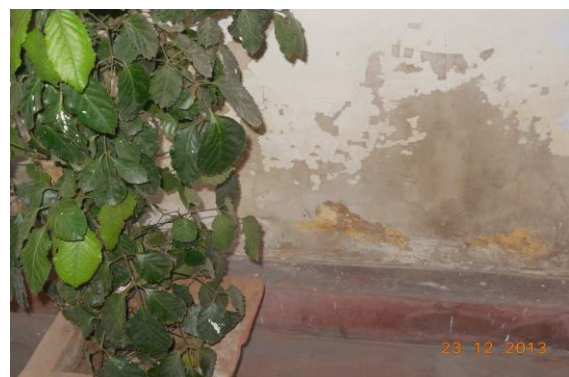
Photo 68

Peeling of Plaster on Wall No. 2 of Main Gate of Ground Floor
