Pre Building Condition Survey Report

Name and Address of Structure :	Badi Chopar Station Area
---------------------------------	--------------------------

Name of the Project	Contract JMRC-UG1B “Design and Construction of Tunnel between Chandpole and Badi Chouper and reverse line by Shield TBM, Underground Metro Stations at Choti Chouper and Badi Chouper by Cut and Cover Methods on East West Corridor of Jaipur Metro Rail Corporation Limited .”	
Owner :

Pre - Condition Building Survey for Construction of Underground Stations from Chandpole to Bari Chouper and reversal line

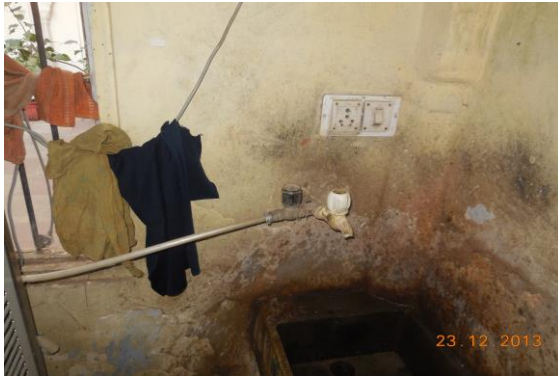
Photo 69

Dampness/Seepage on Wall No. 1 & 4 of Piayu Room of Ground Floor

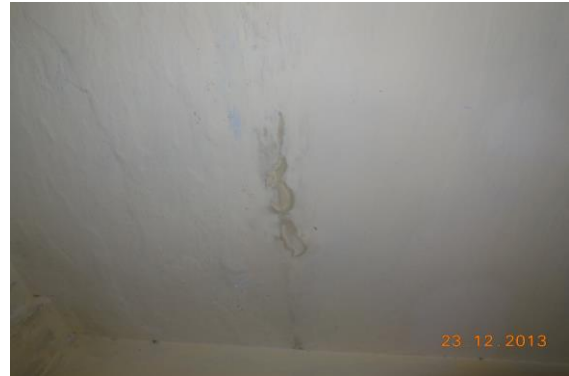
Photo 70

Dampness/Seepage on Roof of Piayu Room of Ground Floor

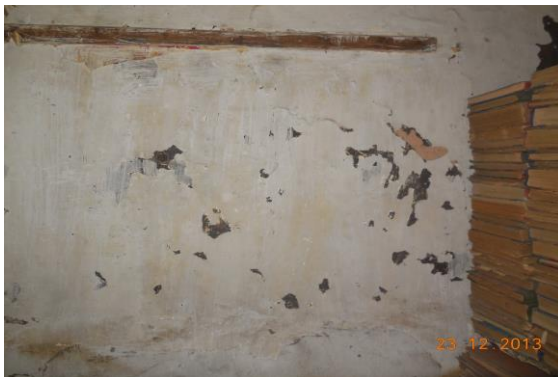
Photo 71

Dampness/Seepage on Wall No. 4 of Store No.1 of Ground Floor

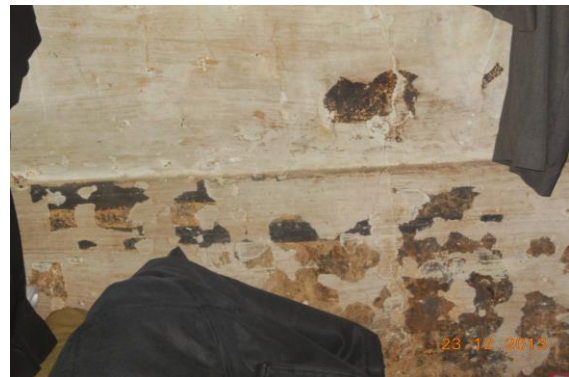
Photo 72

Dampness/Seepage on Wall No. 4 of Store No.2 of Ground Floor

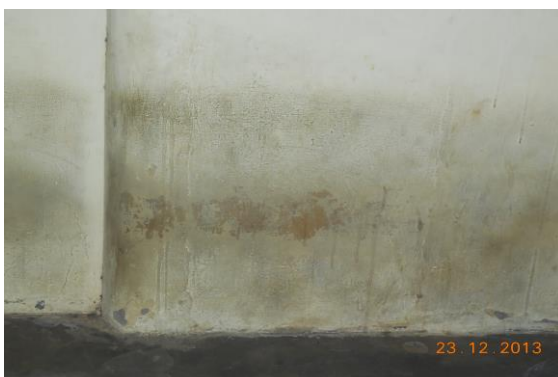
Photo 73

Dampness/Seepage on Wall No. 4 of Lock Up Room of Ground Floor

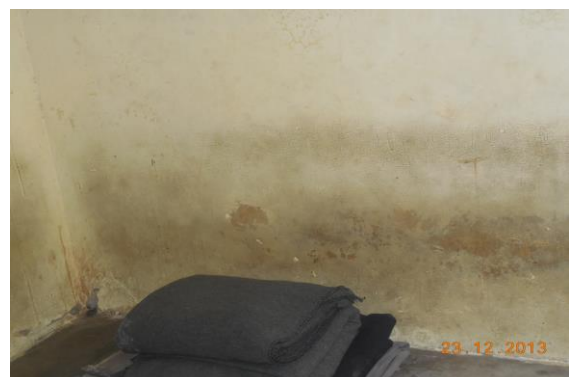
Photo 74

Dampness/Seepage on Wall No. 2 of Lock Up Room of Ground Floor

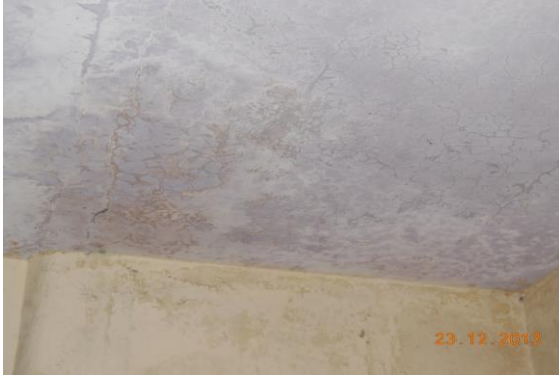
Photo 75
Dampness/Seepage on Roof of Lock Up Room of Ground Floor

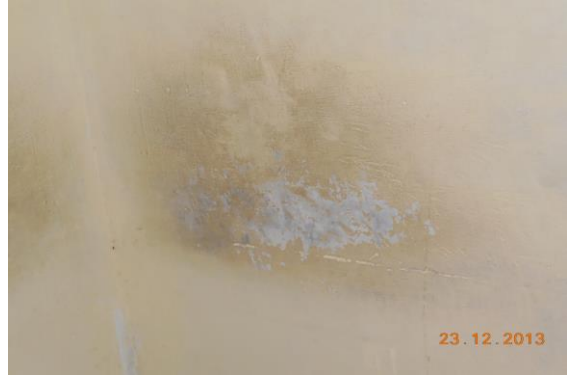
Photo 76
Peeling of Plaster on Wall No. 4 of Room No. 4 of Ground Floor

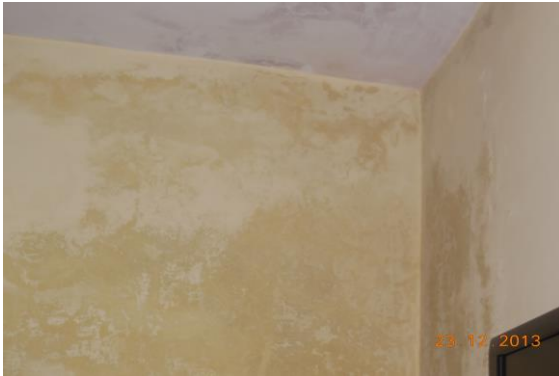
Photo 77
Dampness/Seepage on Wall No. 2, 4 & Roof of Room No. 6 of Ground Floor

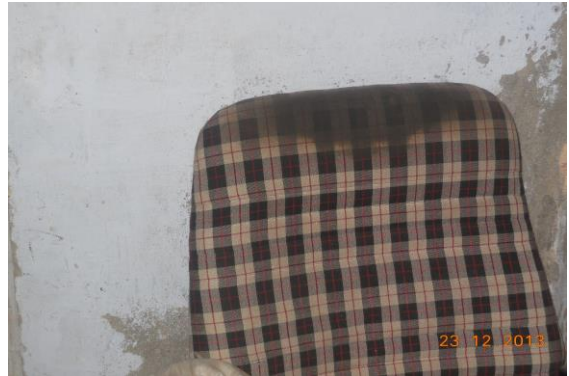
Photo 78
Peeling of Plaster on All Walls & Roof of Hall No. 1 of Ground Floor

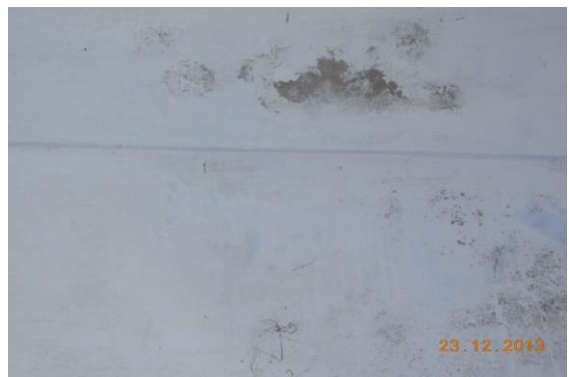
Photo 80
Peeling of Plaster on of Police Station of Ground Floor

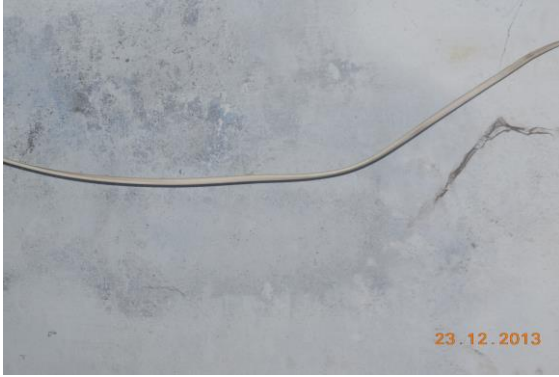
Photo 81
Peeling of Plaster on of Police Station of Ground Floor

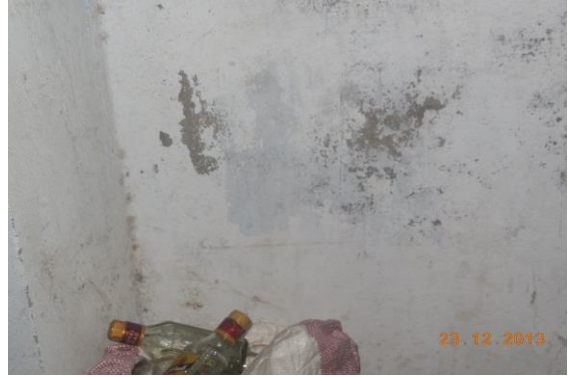
Photo 82
Peeling of Plaster on of Police Station of Ground Floor

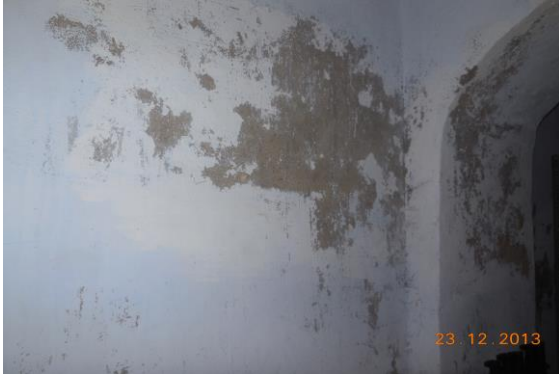
Photo 83
Dampness/Seepage on Wall No. 1 of Room No. 7 of Ground Floor

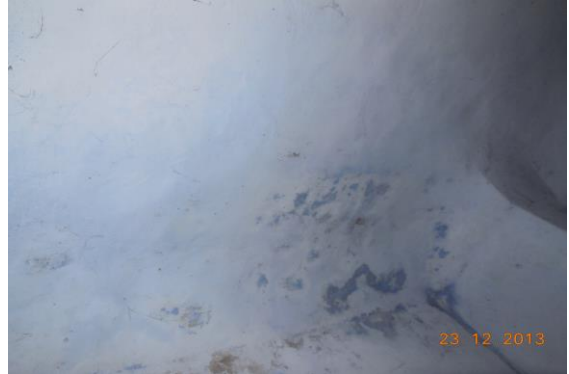
Photo 84
Dampness/Seepage on Roof of Room No. 7 of Ground Floor

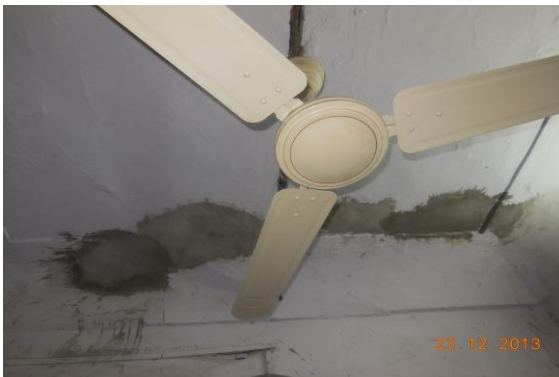
Photo 85
Peeling of Plaster on Roof of Room No. 8 of Ground Floor

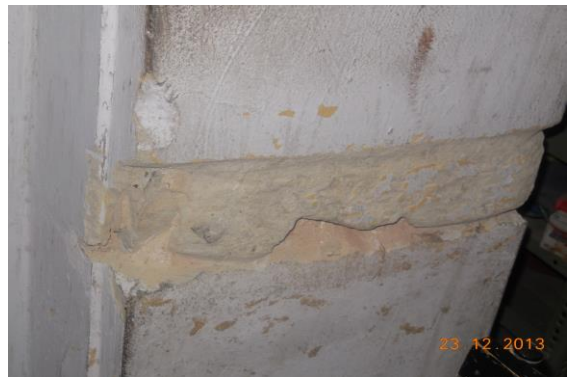
Photo 86
Peeling of Plaster on Wall No. 4 of Room No. 8 of Ground Floor

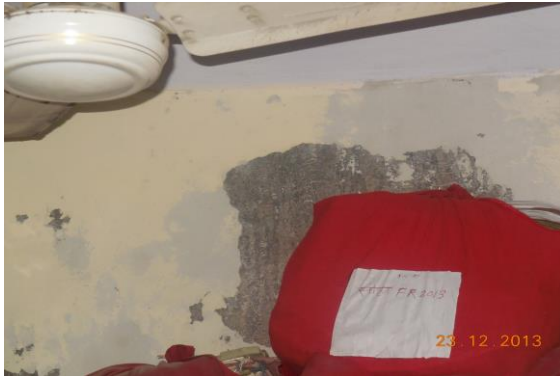
Photo 87

Peeling of Plaster on Wall No. 4 of Hall No. 2 of Ground Floor

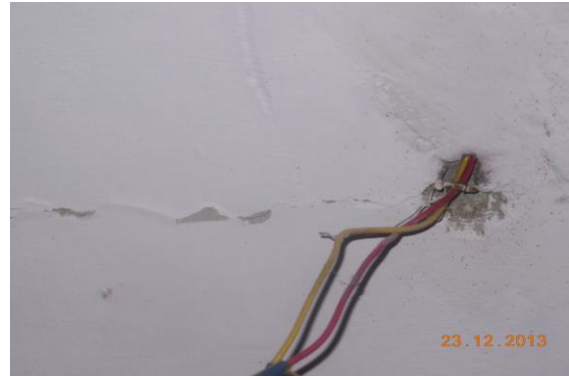
Photo 88

Peeling of Plaster on Roof of Hall No. 2 of Ground Floor

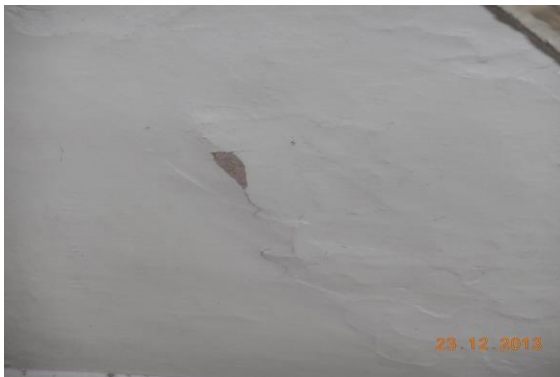
Photo 89

Peeling of Plaster on Roof of Hall No. 2 of Ground Floor

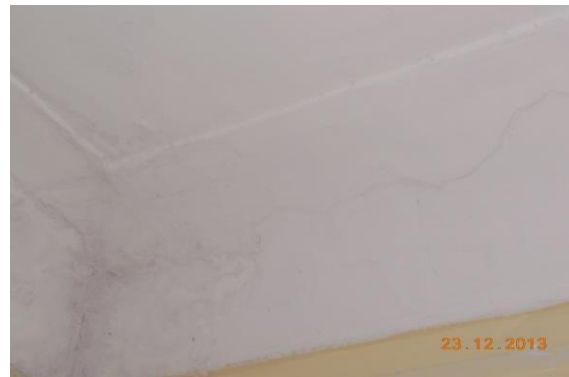
Photo 90

Peeling of Plaster on Roof of Varanda of Ground Floor

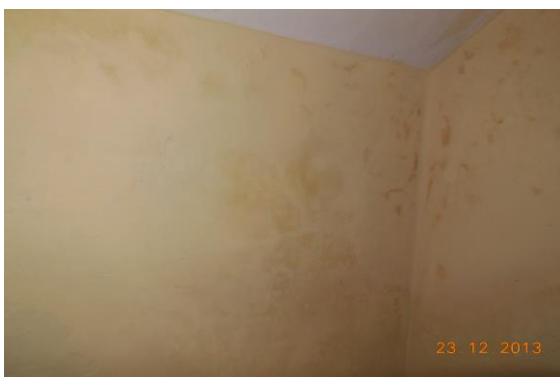
Photo 91

Dampness/Seepage on Wall No. 2 & 3 of Varanda of Ground Floor

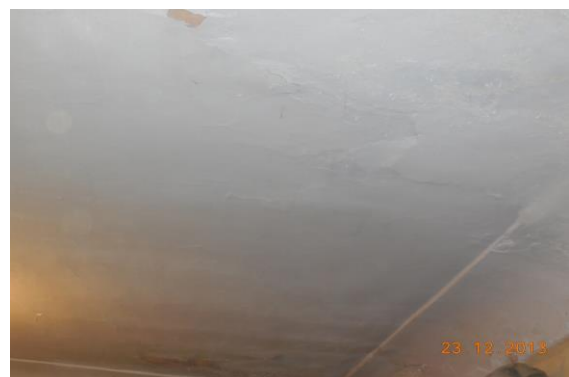
Photo 92

Dampness/Seepage on Roof of Room No. 9 of Ground Floor

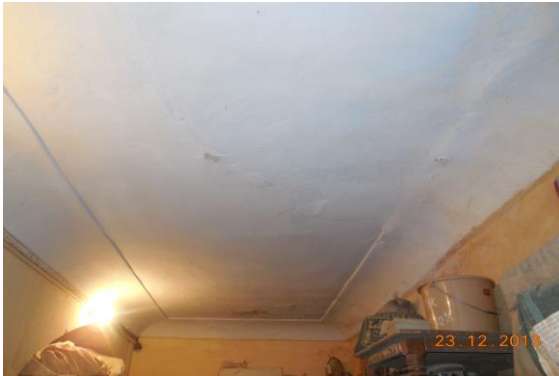
Photo 93

Dampness/Seepage on Wall No. 2 & 4 of Room No. 9 of Ground Floor

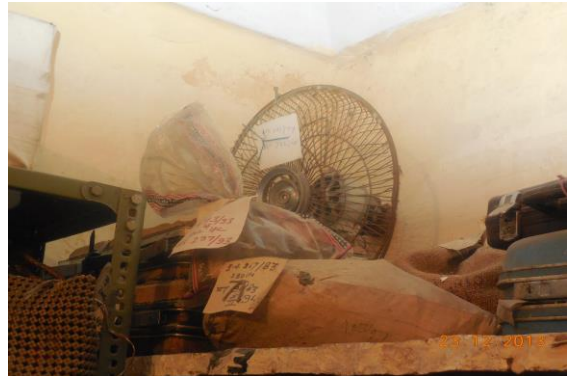
Photo 94

Peeling of Plaster on Roof of Room No. 9 of Ground Floor

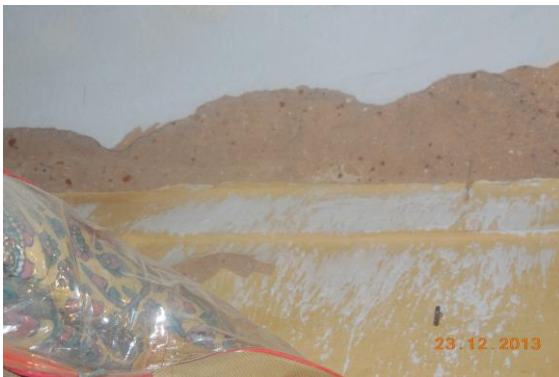
Photo 95

Dampness/Seepage on Wall No. 4 of Room No. 9 of Ground Floor

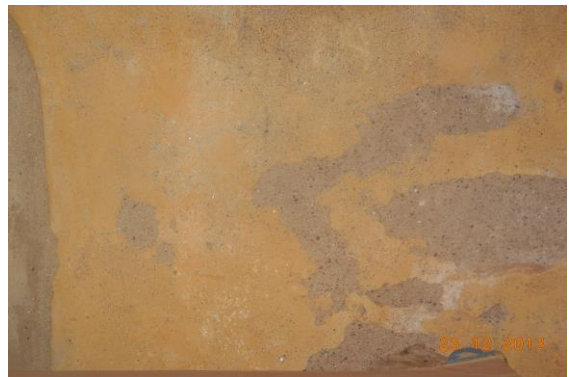
Photo 96

Dampness/Seepage on Wall No. 2 & 4 of Room No. 10 of Ground Floor

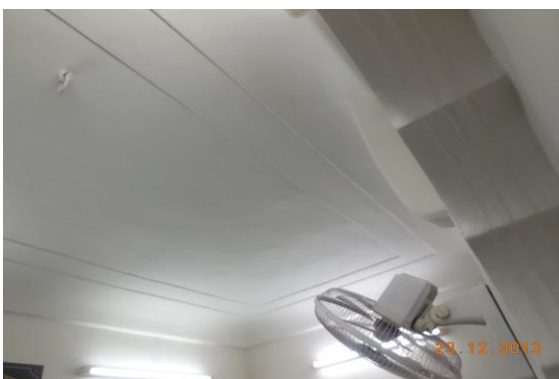
Photo 97

Peeling of Plaster on Wall No. 2 of Staircase Ground Floor to First Floor of Ground Floor

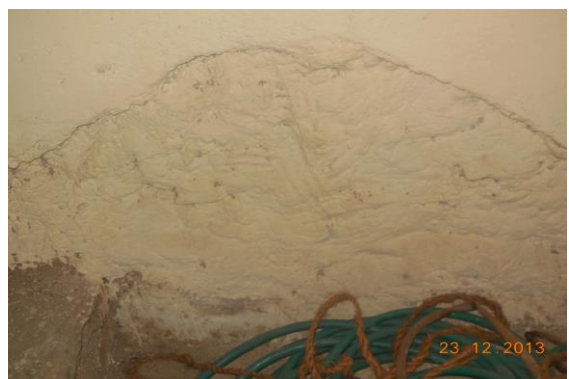
Photo 98

Damaged Portion on Wall No. 1 & Roof of Staircase Ground Floor to First Floor of Ground Floor

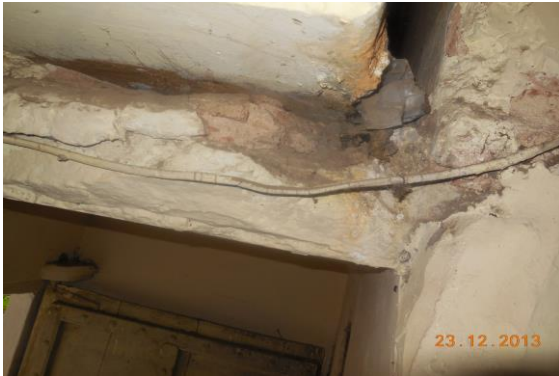
Photo 99

Peeling of Plaster on Steps of Staircase Ground Floor to First Floor of Ground Floor

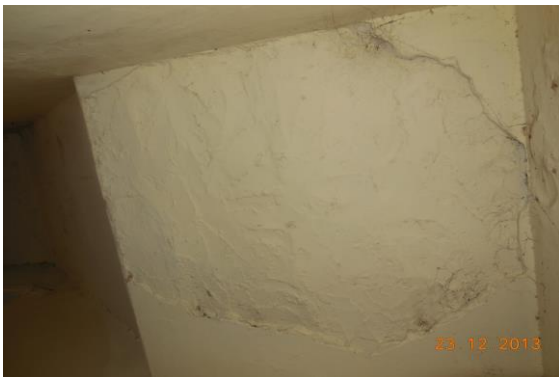
Photo 100

Peeling of Plaster on Roof of Staircase Ground Floor to First Floor of Ground Floor

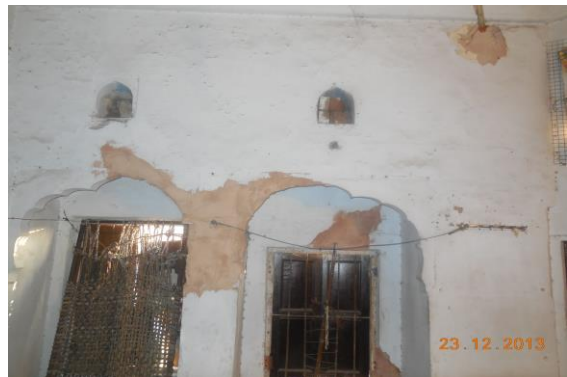
Photo 101

Peeling of Plaster on Wall No. 1 of Hall No. 1 of Second Floor

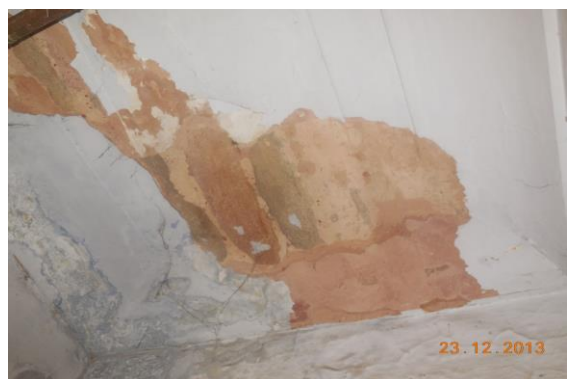
Photo 103

Peeling of Plaster on Roof of Hall No. 1 of Second Floor

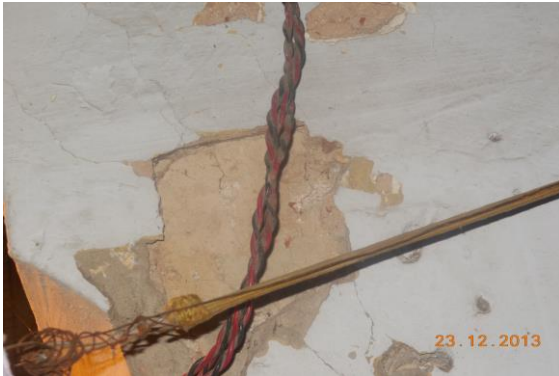
Photo 104

Peeling of Plaster on Wall No. 6 of Hall No. 1 of Second Floor

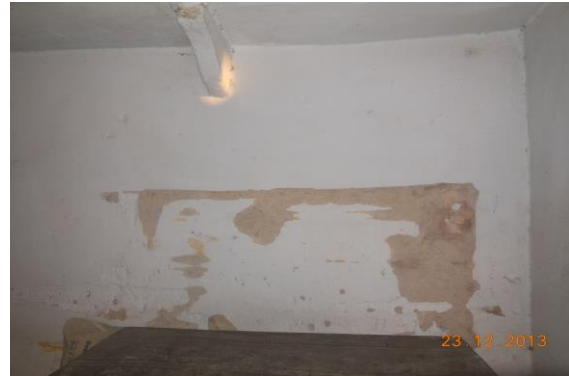
Photo 105
Peeling of Plaster on Wall No. 3 of Hall No. 1 of Second Floor

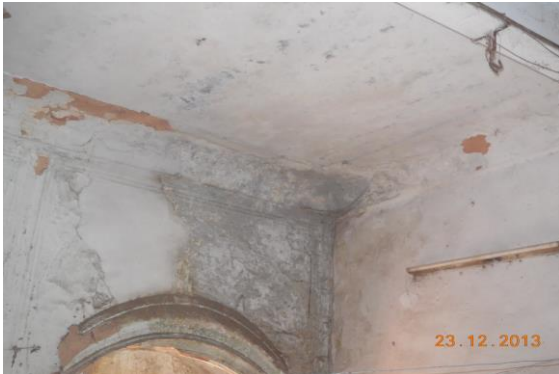
Photo 106
Dampness/Seepage on Wall No. 1, 3 & Roof of Hall No. 1 of Second Floor

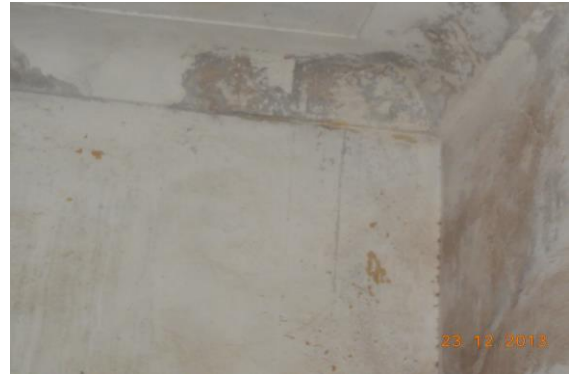
Photo 107
Dampness/Seepage on Wall No. 1, 4 & Roof of Police Station of Second Floor

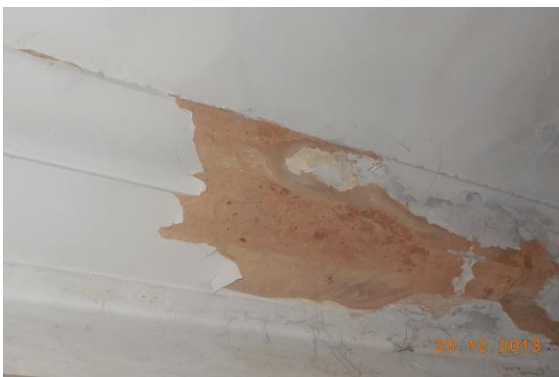
Photo 108
Peeling of Plaster on Roof of Hall No. 2 of Second Floor

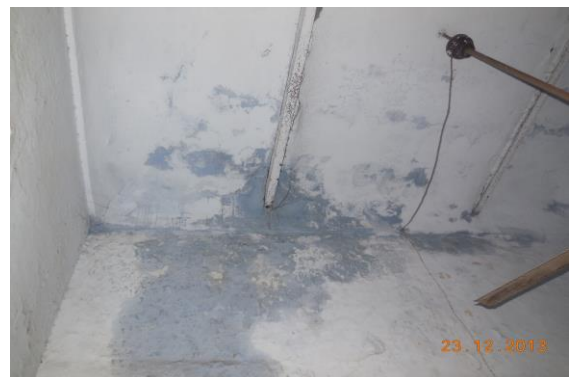
Photo 109
Dampness/Seepage on Wall No. 1 & Roof of Room No. 1 (Part A) of Second Floor

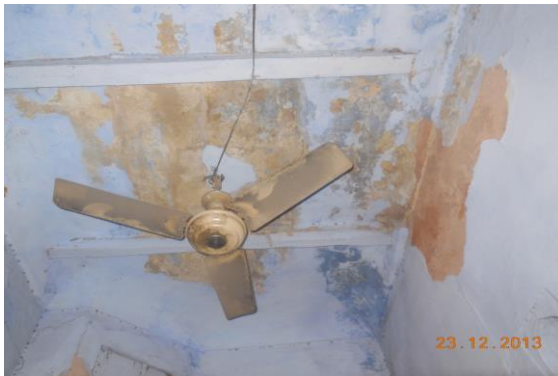
Photo 110
Dampness/Seepage on Wall No. 2, 4 & Roof of Room No. 1 (Part B) of Second Floor

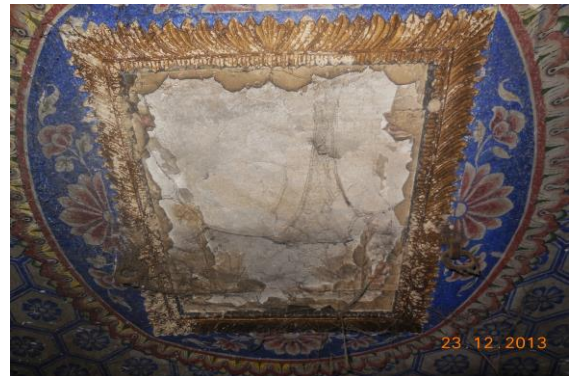
Photo 111

Peeling of Plaster on Roof of Bathroom of Second Floor

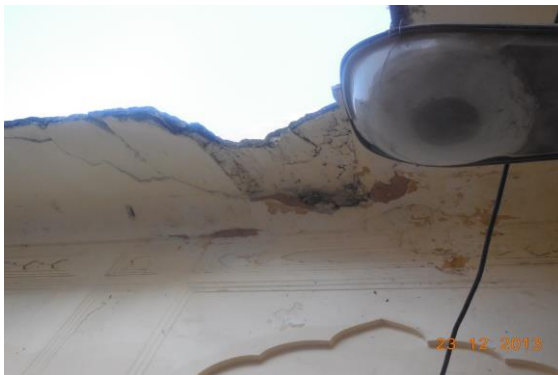
Photo 112

Damaged Portion on Wall No. 4 & Shade of Open Sky of Second Floor

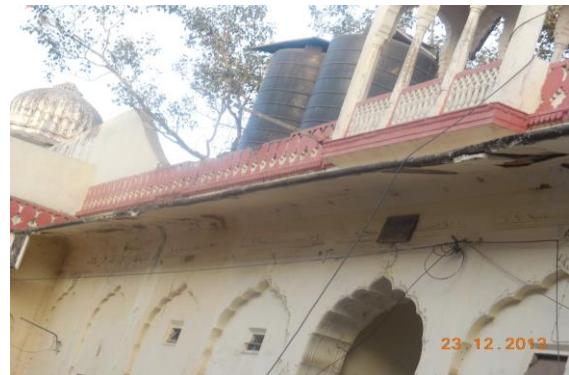
Photo 113

Damaged Portion on Wall No. 4 & Shade of Open Sky of Second Floor

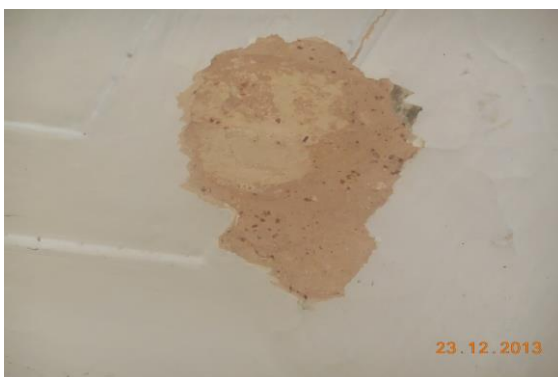
Photo 114

Peeling of Plaster on Roof of Hall No. 3 of Second Floor

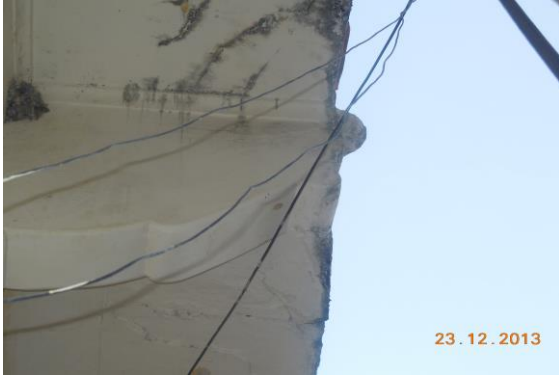
Photo 116

Damaged Portion on Wall No. 1 & Shade of Open Sky of Second Floor

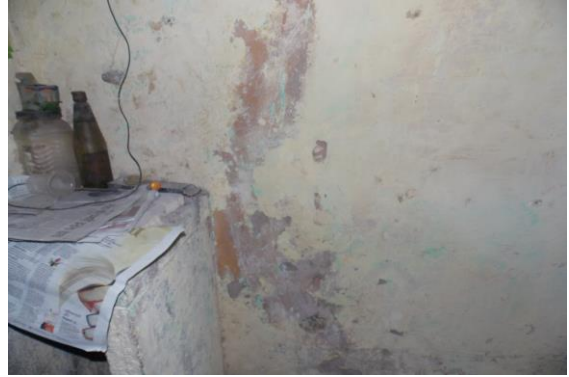
Photo 117

Damaged Portion on Wall No. 1 & Shade of Open Sky of Second Floor

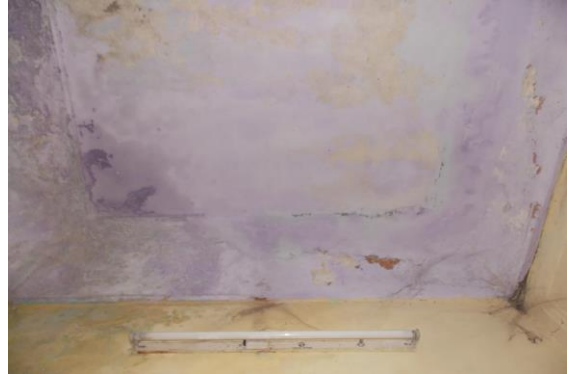
Photo 119

Peeling of Plaster on Wall No. 1 of Hall No. 6 of Second Floor

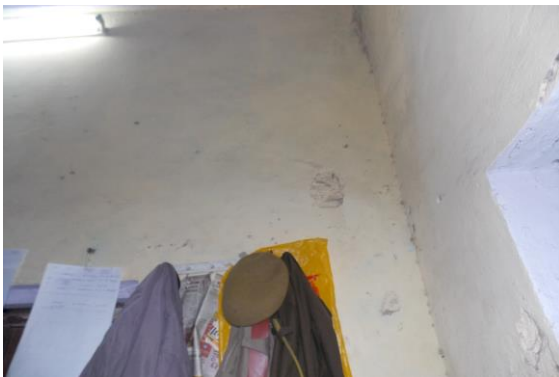
Photo 120

Dampness/Seepage on Roof of Hall No. 6 of Second Floor

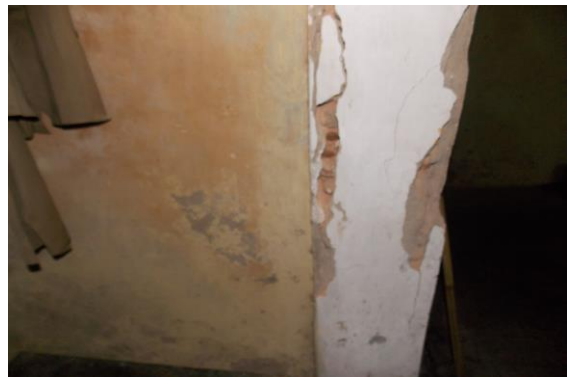
Photo 121

Peeling of Plaster on Wall No. 3 of Hall No. 6 of Second Floor

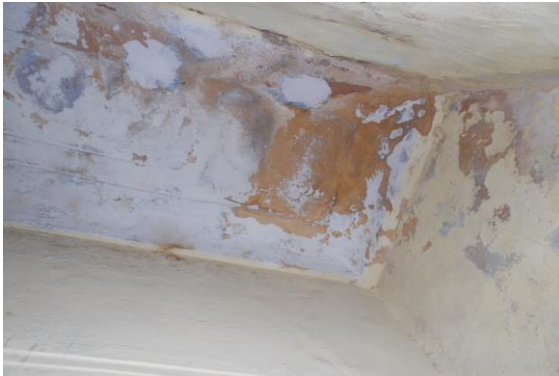
Photo 122

Damaged Portion on Wall No. 2 of Varanda of Second Floor

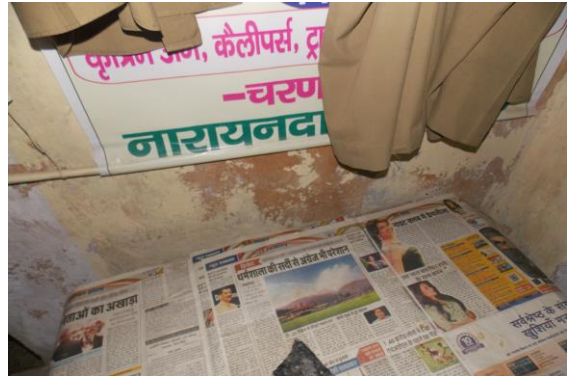
Photo 123
Dampness/Seepage on Roof of Varanda of Second Floor

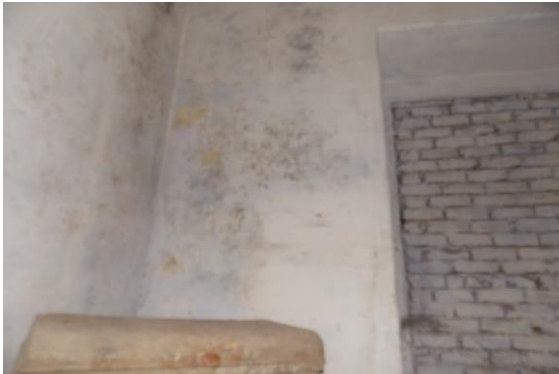
Photo 124
Dampness/Seepage on Wall No. 1 of Varanda of Second Floor

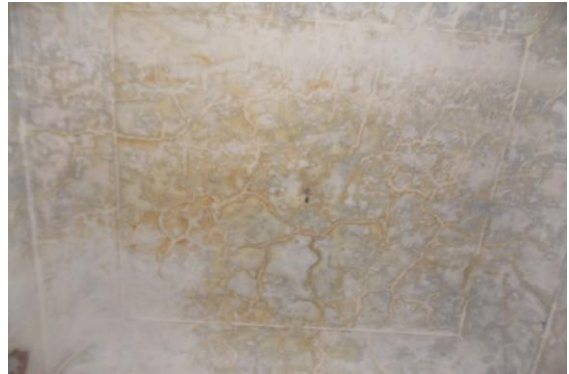
Photo 125
Dampness/Seepage on Wall No. 4 of Varanda of Second Floor

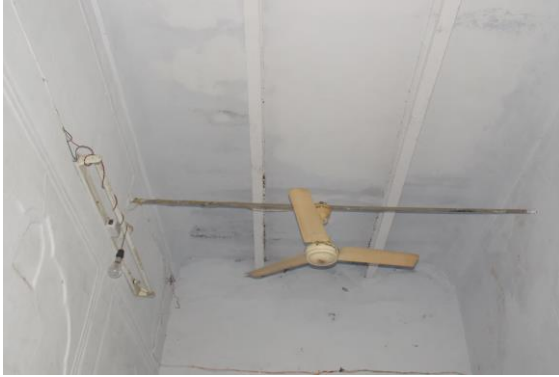
Photo 128
Damaged Portion on Roof of Hall No. 6 of Second Floor

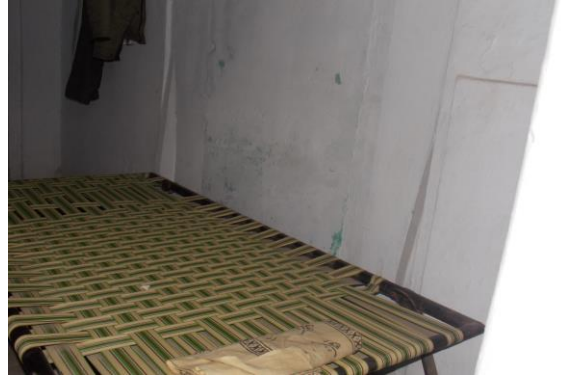
Photo 129
Dampness/Seepage on Roof of Room No. 3 of Second Floor

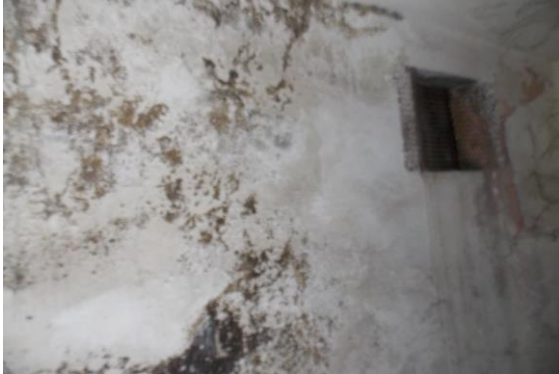
Photo 130
Peeling of Plaster on Wall No. 2 of Room No. 3 of Second Floor

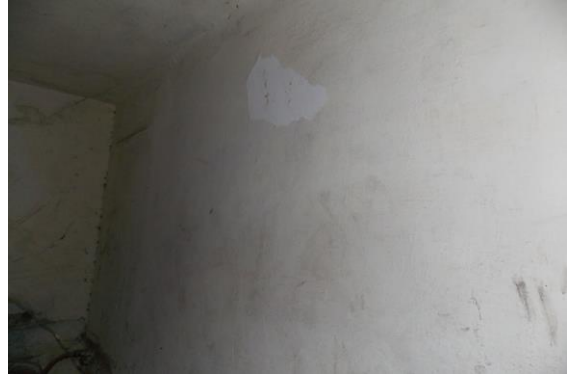
Photo 131
Peeling of Plaster on Wall No. 4 of Toilet & Washroom of Second Floor

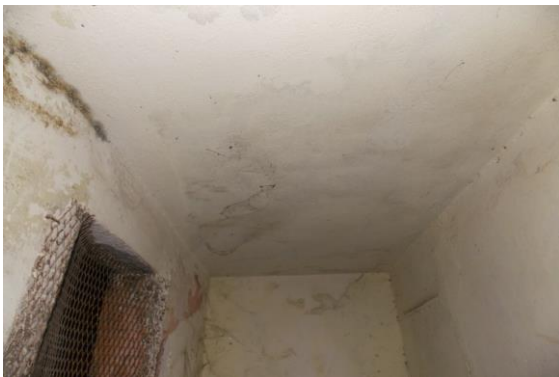
Photo 132
Peeling of Plaster on Wall No. 3 of Toilet & Washroom of Second Floor

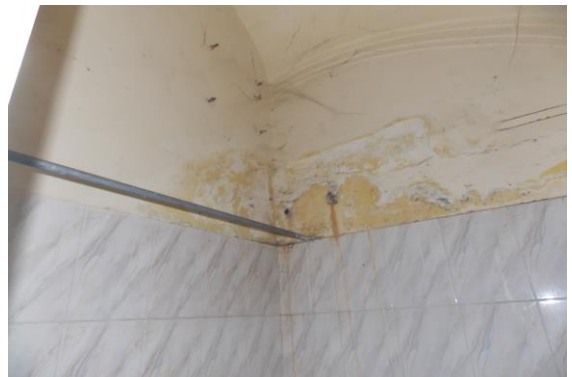
Photo 133
Dampness/Seepage on Roof of Toilet & Washroom of Second Floor

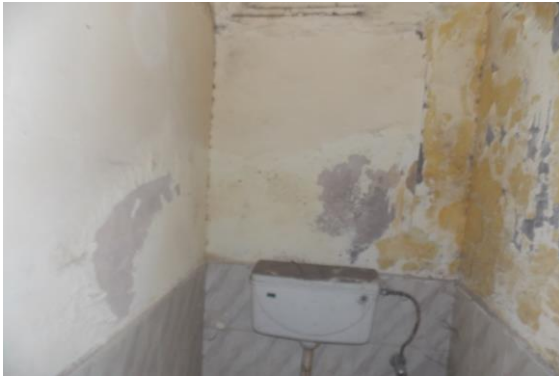
Photo 134
Dampness/Seepage on Wall No. 2, 4 & Roof of Bathroom of Second Floor

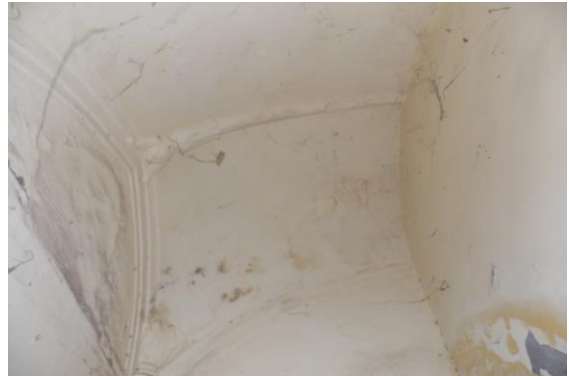
Photo 135

Dampness/Seepage on Wall No. 1, 4 & 2 of Toilet No. 1 of Second Floor

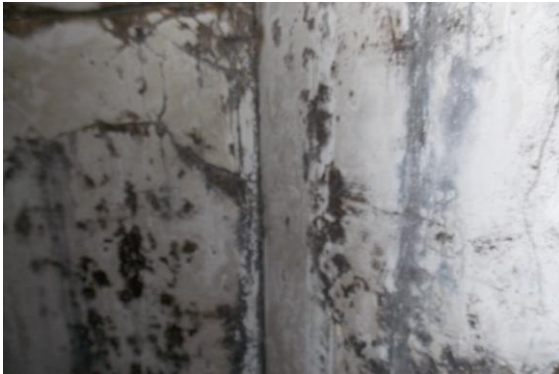
Photo 136

Dampness/Seepage on Roof of Toilet No. 1 of Second Floor

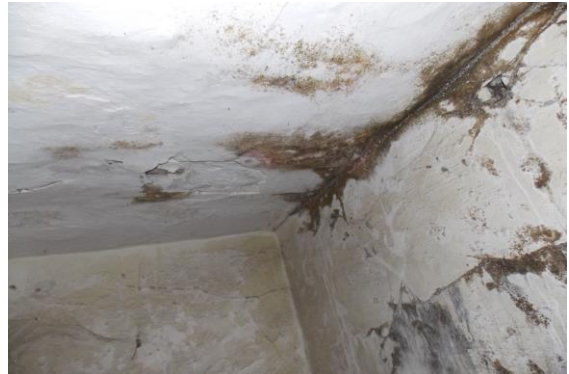
Photo 137

Dampness/Seepage on Wall No. 4 of Lobby of Second Floor

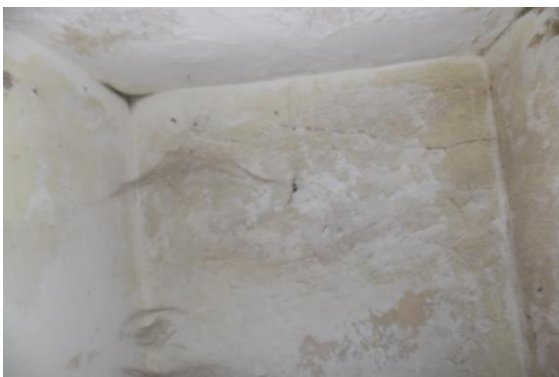
Photo 138

Dampness/Seepage on Roof of Lobby of Second Floor

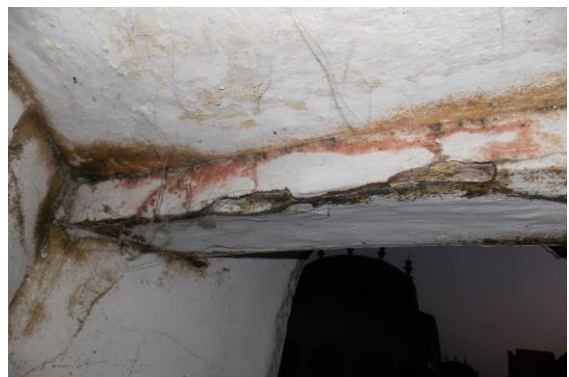
Photo 140

Peeling of Plaster on Roof of Lobby of Second Floor

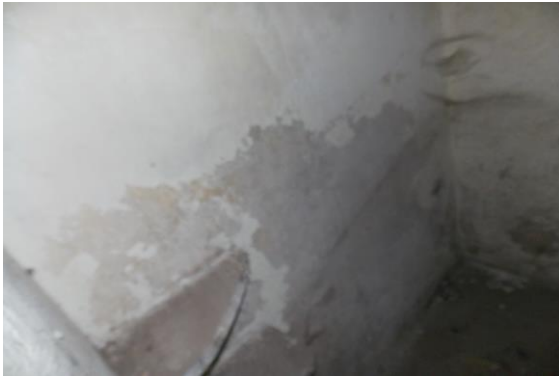
Photo 141
Peeling of Plaster on Wall No. 3 of Lobby of Second Floor

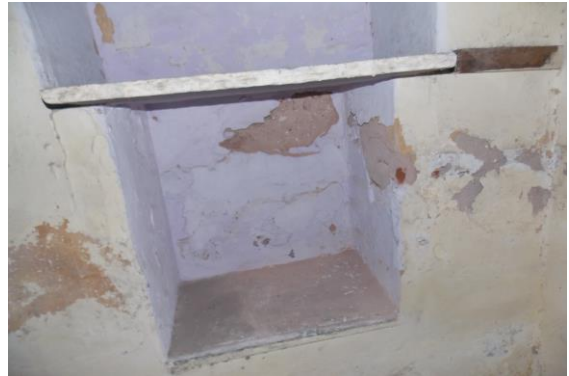
Photo 142
Peeling of Plaster on Wall No. 4 of Room No. 2 of Second Floor

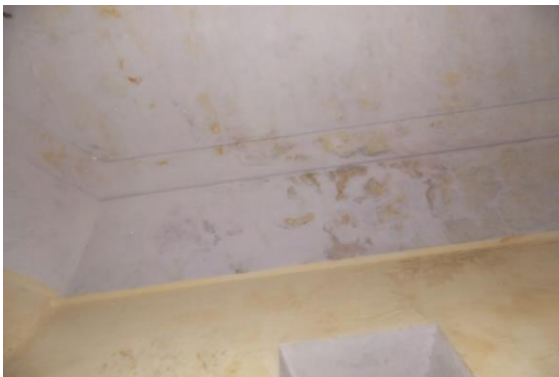
Photo 143
Dampness/Seepage on Roof of Room No. 2 of Second Floor

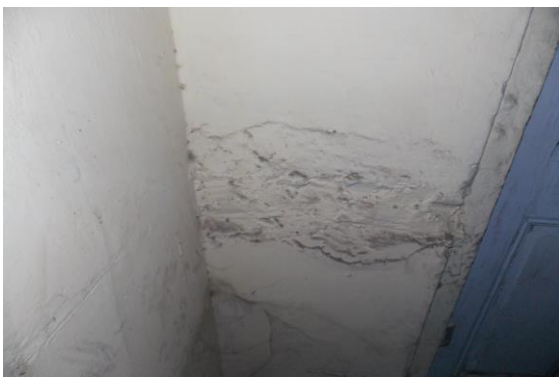
Photo 145
Peeling of Plaster on Wall No. 4 of Room No. 1 of Second Floor

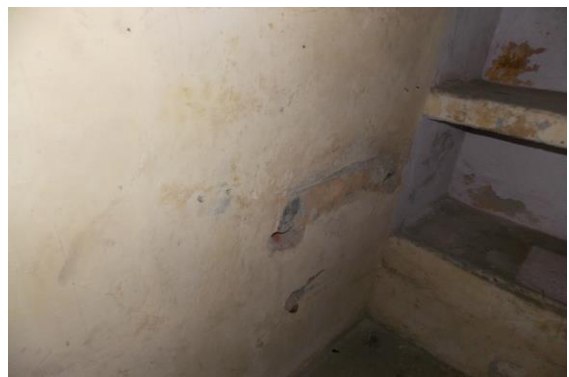
Photo 146
Peeling of Plaster on Wall No. 1 of Room No. 1 of Second Floor

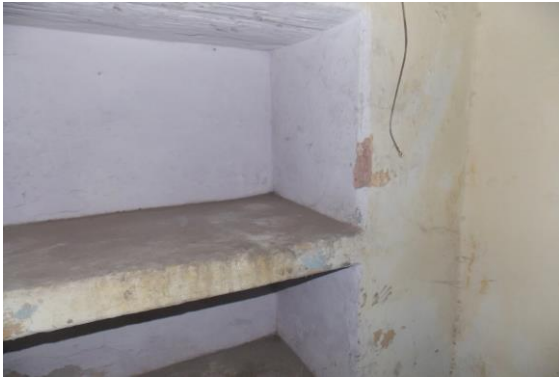
Photo 147

Peeling of Plaster on Wall No. 2 of Room No. 1 of Second Floor

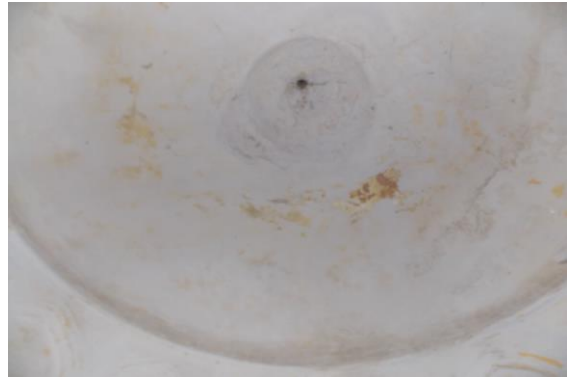
Photo 148

Peeling of Plaster on Roof of Tomb No.1 of Second Floor

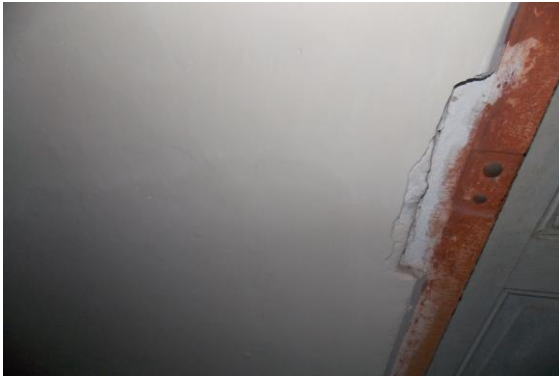
Photo 149

Peeling of Plaster on Outer Wall No.3 of Room No. 4 of Second Floor

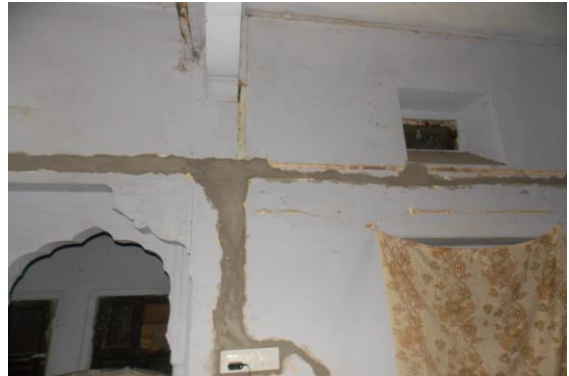
Photo 150

Peeling of Plaster on Wall No. 1 of Room No. 5 of Second Floor

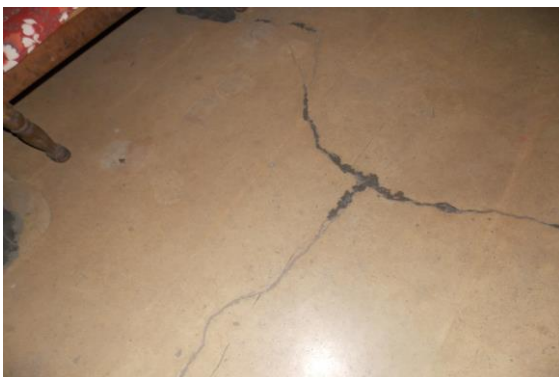
Photo 151

Peeling of Plaster on Floor of Room No. 5 of Second Floor

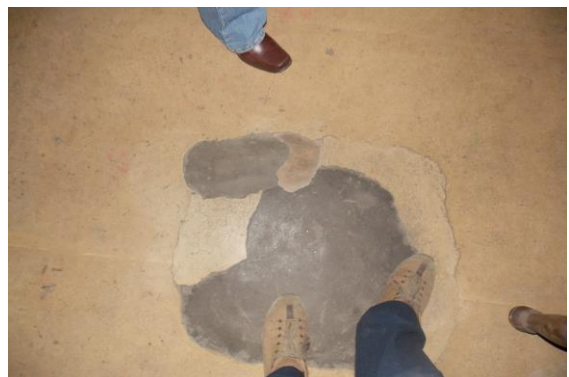
Photo 152

Peeling of Plaster on Floor of Room No. 5 of Second Floor

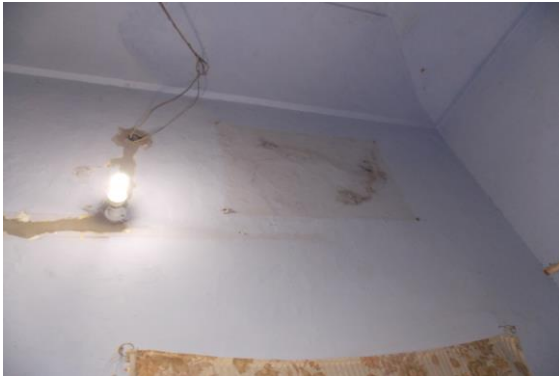
Photo 153
Peeling of Plaster on Wall No. 3 of Room No. 6 of Second Floor

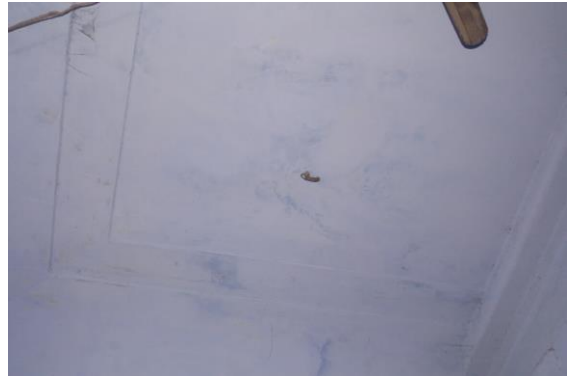
Photo 154
Dampness/Seepage on Roof of Room No. 6 of Second Floor

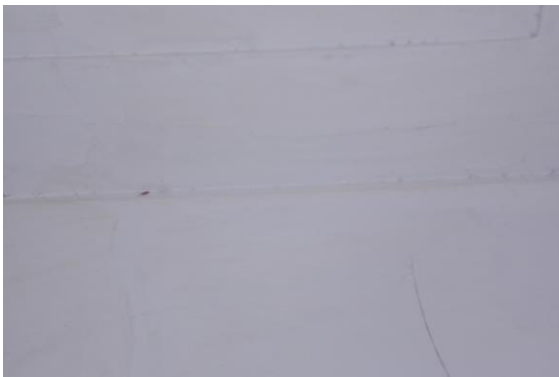
Photo 155
Peeling of Plaster on Roof of Room No. 6 of Second Floor

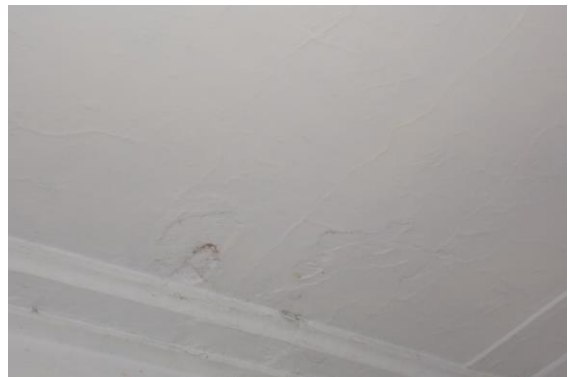
Photo 156
Peeling of Plaster on Roof of Room No. 7 of Second Floor

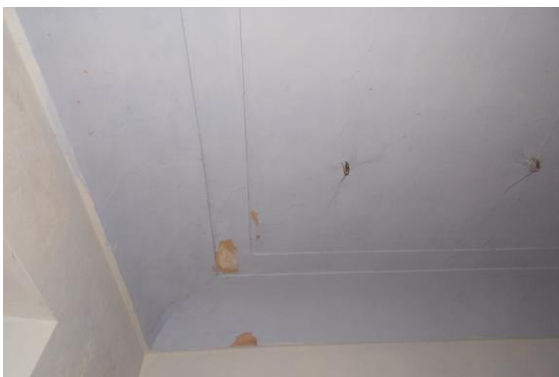
Photo 157
Peeling of Plaster on Roof of Room No. 7 of Second Floor

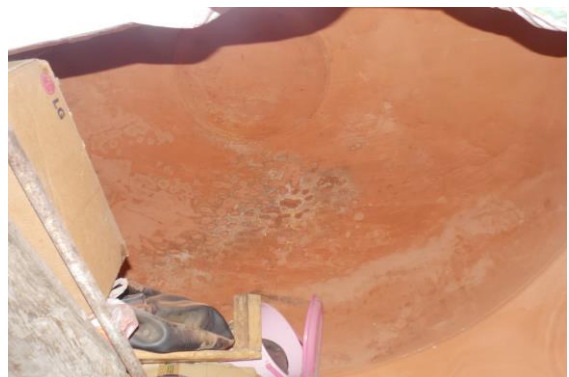
Photo 158
Dampness/Seepage on Roof of Tomb No.3 of Second Floor

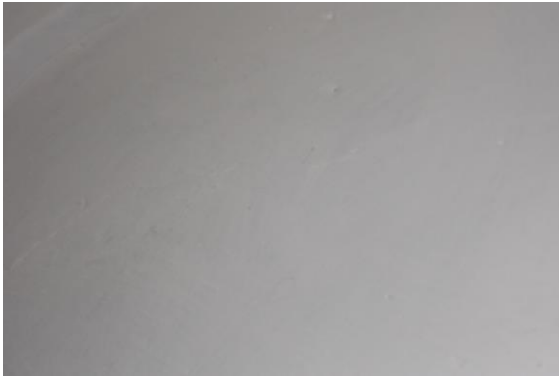
Photo 159
Peeling of Plaster on Wall No. 2 of Kitchen of Second Floor

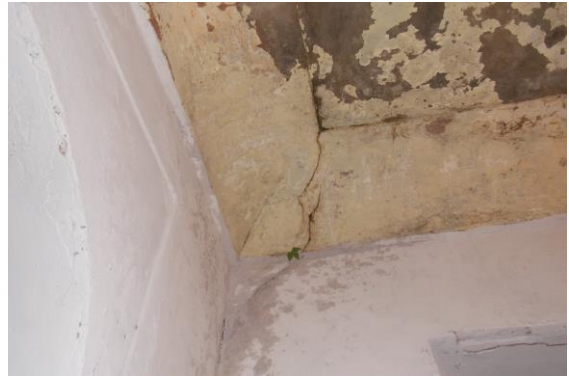
Photo 160
Peeling of Plaster on Roof of Varanda No.3 of Second Floor

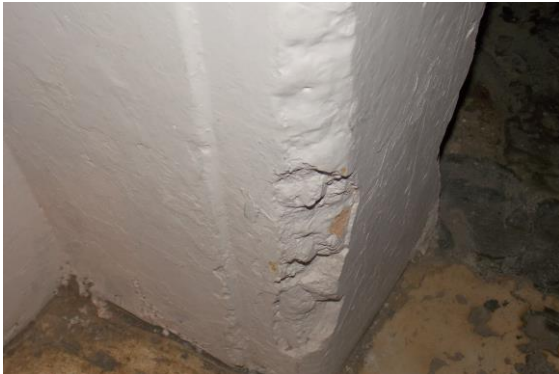
Photo 161
Peeling of Plaster on Wall No. 1 of Varanda No.3 of Second Floor

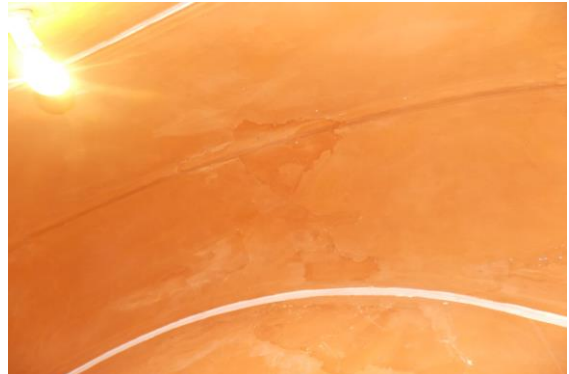
Photo 162
Peeling of Plaster on Roof of Toilet & Washroom of Second Floor

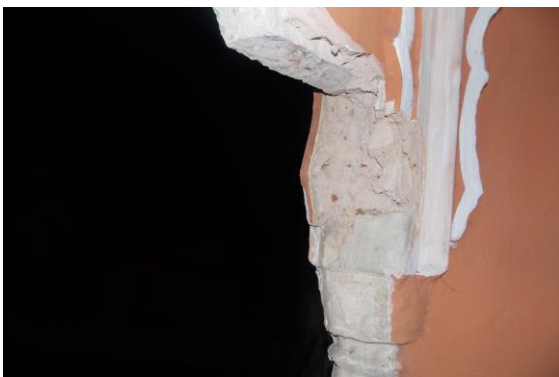
Photo 163
Damaged Portion on Gate of Tomb No.4 of Second Floor

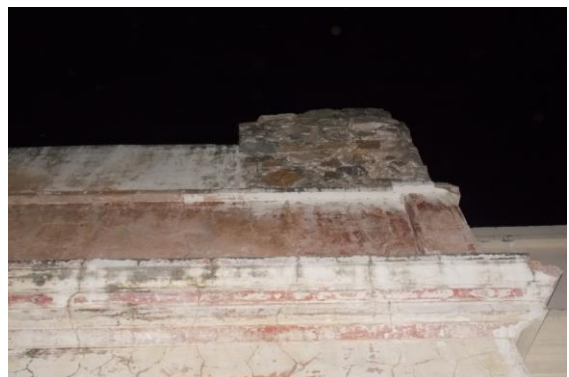
Photo 164
Damaged Portion on Wall No. 3 of Open Varanda No.2 of Second Floor

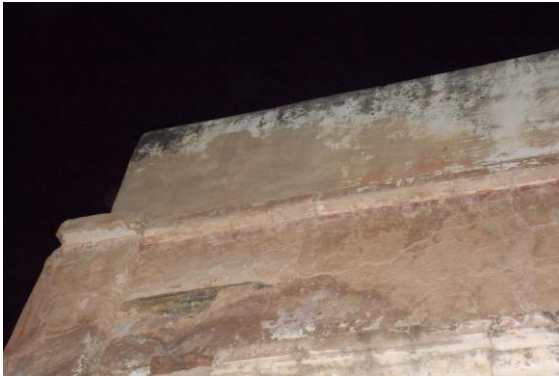
Photo 165

Peeling of Plaster on Wall No. 3 of Open Varanda No.2 of Second Floor

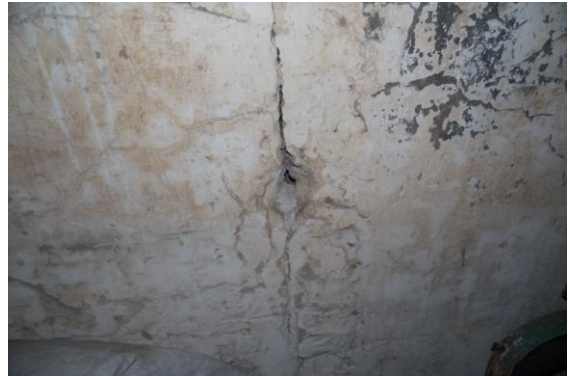
Photo 166

Damaged Portion on Wall No. 4 of Open Varanda No.2 of Second Floor

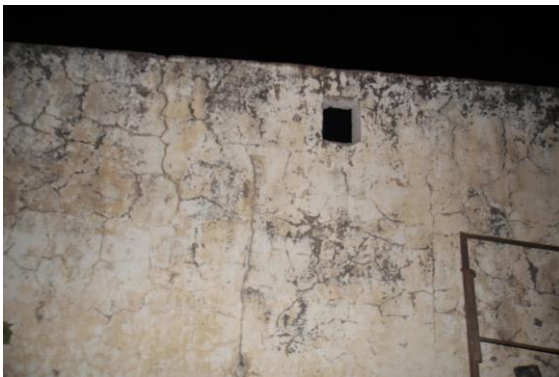
Photo 167

Peeling of Plaster on Wall No. 4 of Open Varanda No.2 of Second Floor

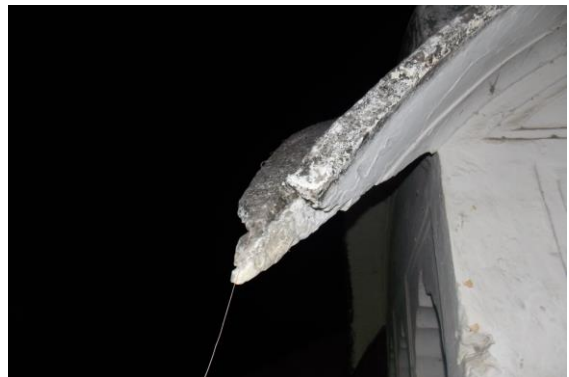
Photo 168

Damaged Portion on Shade of Minarates of Second Floor

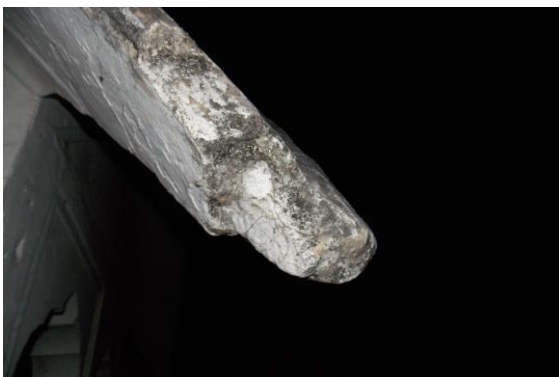
Photo 169

Damaged Portion on Shade of Minarates of Second Floor

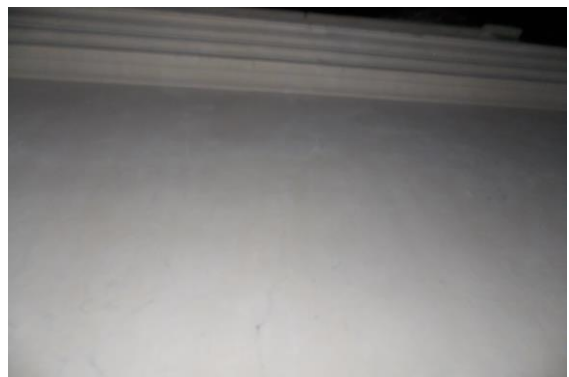
Photo 170

Peeling of Plaster on Wall No. 3 of Open Varanda of Second Floor

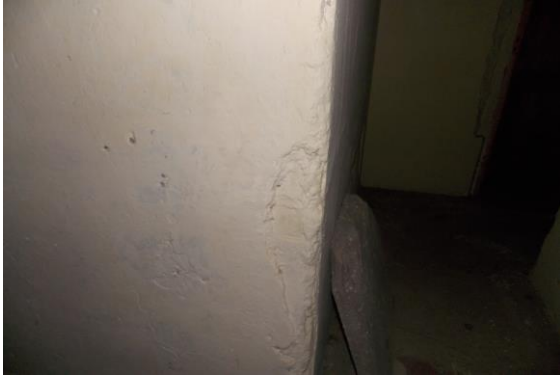
Photo 171
Peeling of Plaster on Wall No. 3 of Open Varanda of Second Floor

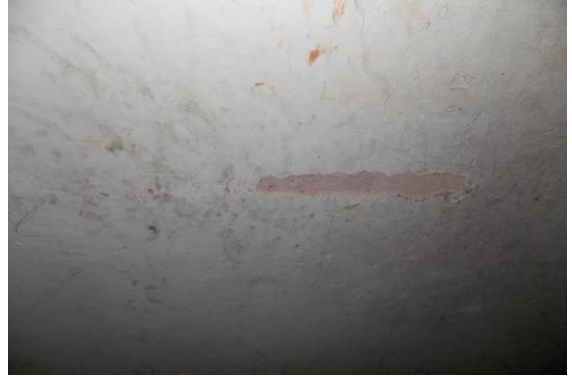
Photo 172
Peeling of Plaster on Wall No. 2 of Staircase First Floor To Second Floor of Second Floor

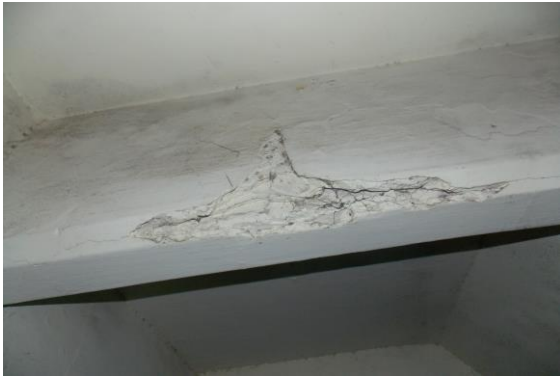
Photo 173
Damaged Portion on Wall No. 1 of Staircase First Floor To Second Floor of Second Floor

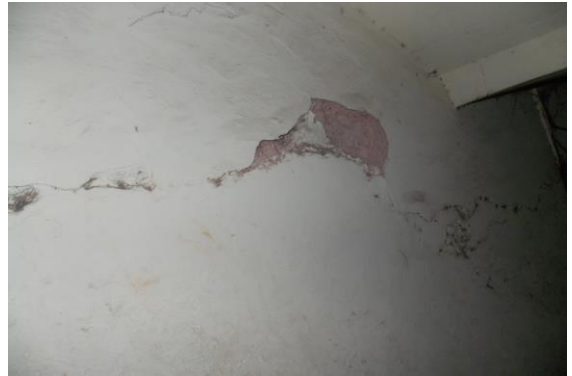
Photo 174
Peeling of Plaster on Wall No. 2 of Staircase First Floor To Second Floor of Second Floor

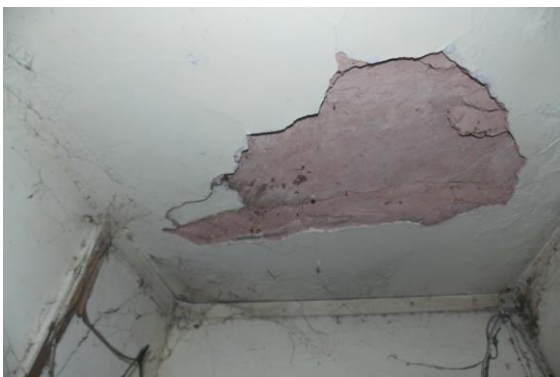
Photo 175
Peeling of Plaster on Roof of Staircase First Floor To Second Floor of Second Floor
