Pre Building Condition Survey Report

Name and Address of Structure :	Badi Chopar Station Area
---------------------------------	--------------------------

Name of the Project	Contract JMRC-UG1B “Design and Construction of Tunnel between Chandpole and Badi Chouper and reverse line by Shield TBM, Underground Metro Stations at Choti Chouper and Badi Chouper by Cut and Cover Methods on East West Corridor of Jaipur Metro Rail Corporation Limited .”	
Owner :

Pre - Condition Building Survey for Construction of Underground Stations from Chandpole to Bari Chouper and reversal line

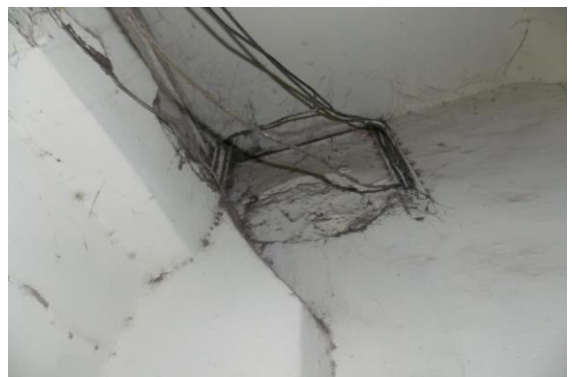
Photo 176
Peeling of Plaster on Wall No. 2 of Staircase First Floor To Second Floor of Second Floor

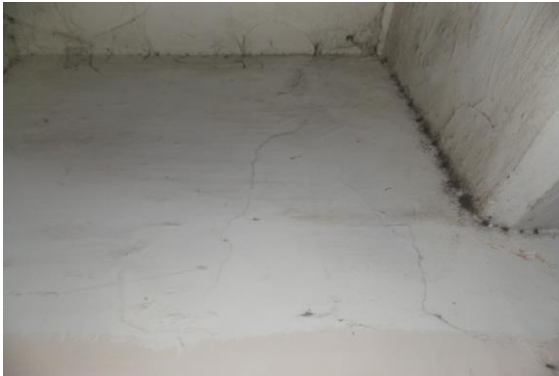
Photo 177

Peeling of Plaster on Wall No. 3 of Staircase First Floor To Second Floor of Second Floor

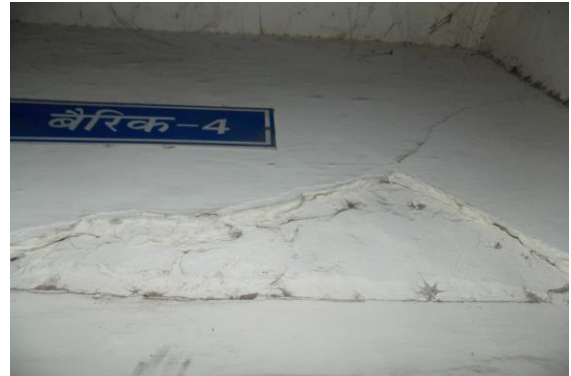
Photo 178

Damaged Portion on Wall No. 2 of Staircase First Floor To Second Floor of Second Floor

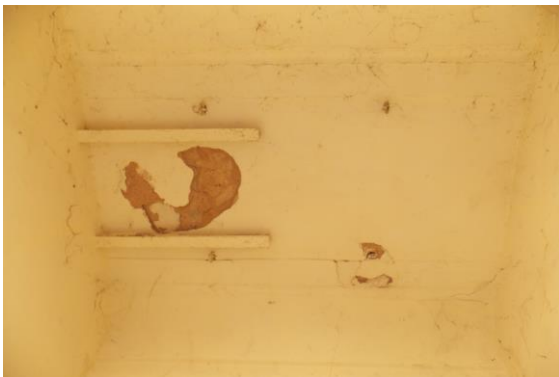
Photo 179

Peeling of Plaster on Roof of Gate of Temple Shri Anand Bihari Ji, First Floor

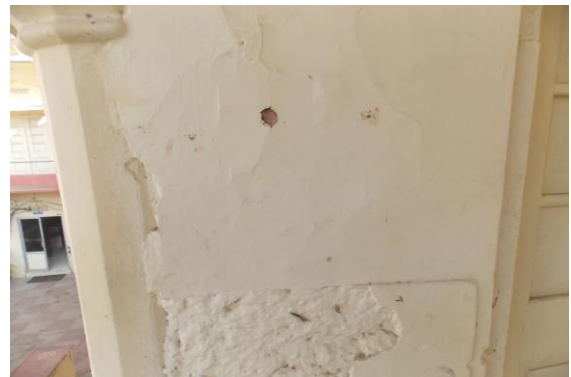
Photo 180

Peeling of Plaster on Wall No. 1 of Gate of Temple Shri Anand Bihari Ji, First Floor

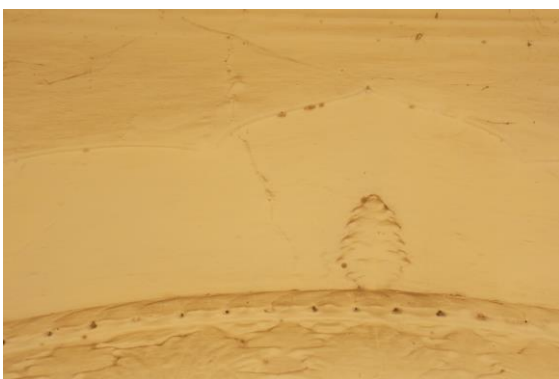
Photo 181

Peeling of Plaster on Wall No. 4 of Gate of Temple Shri Anand Bihari Ji, First Floor

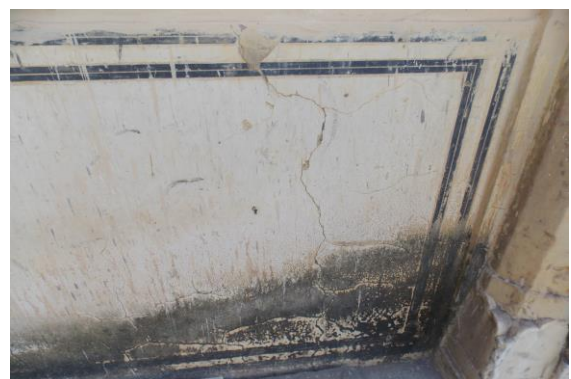
Photo 182

Peeling of Plaster on Wall No. 4 of Open Sky of Temple Shri Anand Bihari Ji, First Floor

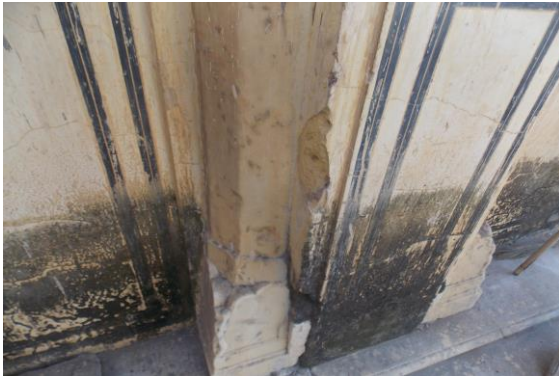
Photo 183

Peeling of Plaster on Wall No. 4 of Open Sky of Temple Shri Anand Bihari Ji, First Floor

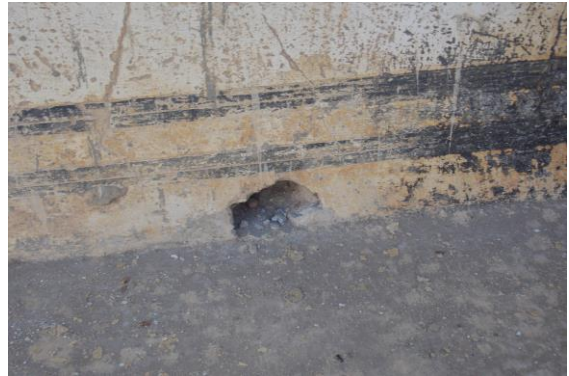
Photo 184

Peeling of Plaster on Wall No. 4 of Open Sky of Temple Shri Anand Bihari Ji, First Floor

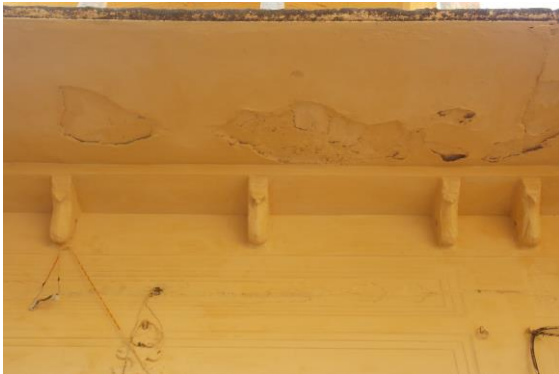
Photo 185

Peeling of Plaster on Wall No. 1 of Sun Shade of Temple Shri Anand Bihari Ji, First Floor

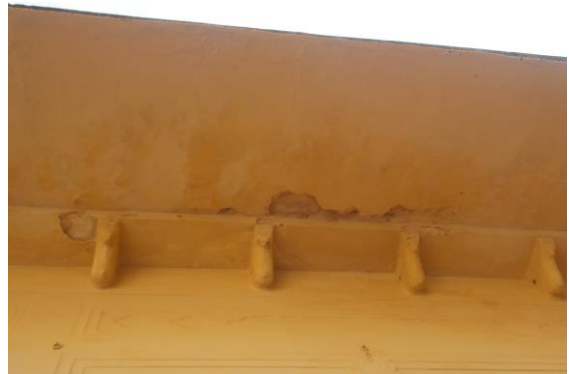
Photo 186

Peeling of Plaster on Wall No. 4 of Sun Shade of Temple Shri Anand Bihari Ji, First Floor

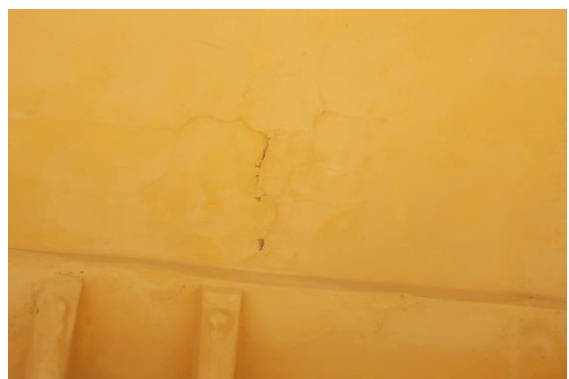
Photo 188

Peeling of Plaster on Wall No. 3 of Sun Shade of Temple Shri Anand Bihari Ji, First Floor

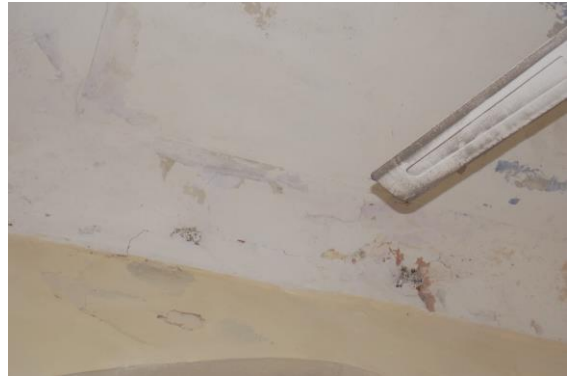
Photo 190

Dampness/Seepage on Roof of Room No. 2 of Temple Shri Anand Bihari Ji, First Floor

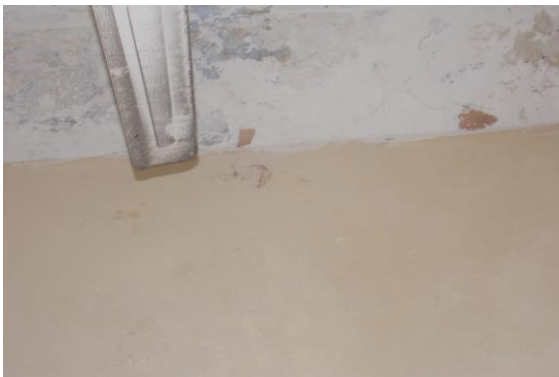
Photo 191

Dampness/Seepage on Wall No. 4 of Room No. 2 of Temple Shri Anand Bihari Ji, First Floor

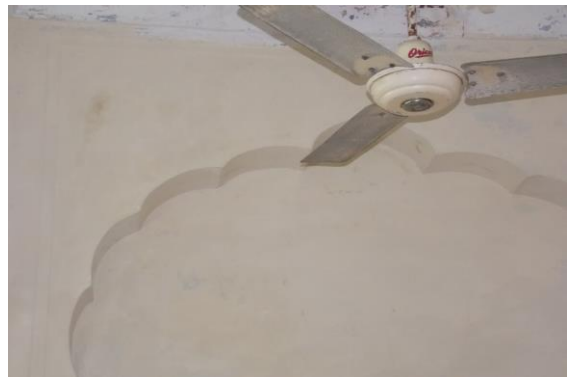
Photo 192

Dampness/Seepage on Wall No. 1 of Room No. 2 of Temple Shri Anand Bihari Ji, First Floor

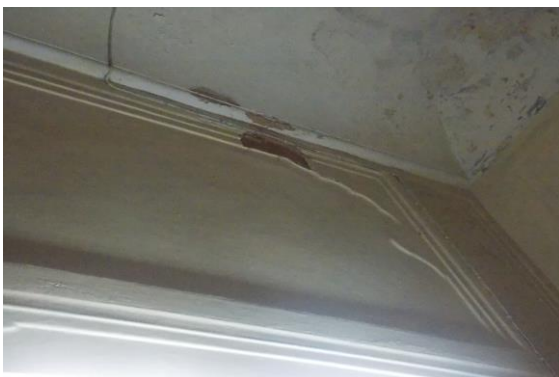
Photo 193

Peeling of Plaster on Wall No. 3 of Room No. 2 of Temple Shri Anand Bihari Ji, First Floor

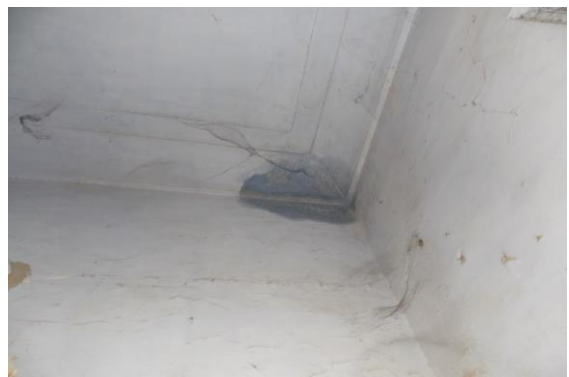
Photo 194

Dampness/Seepage on Wall No. 2 & Roof of Room No. 9 of Temple Shri Anand Bihari Ji, First Floor

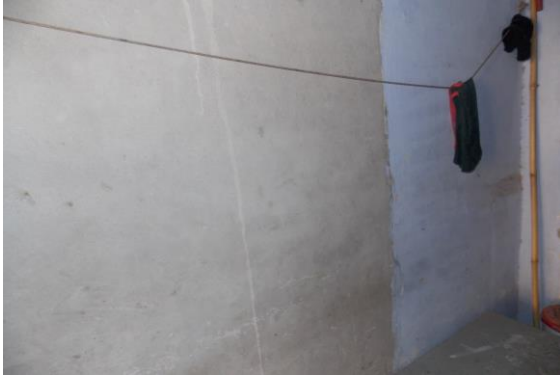
Photo 195

Peeling of Plaster on Wall No. 1 of Room No. 9 of Temple Shri Anand Bihari Ji, First Floor

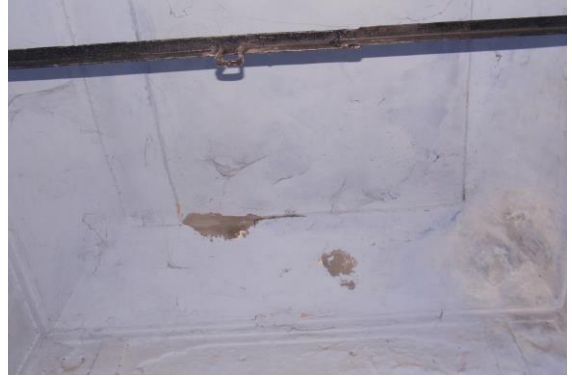
Photo 196

Peeling of Plaster on Roof of Room No. 8 of Temple Shri Anand Bihari Ji, First Floor

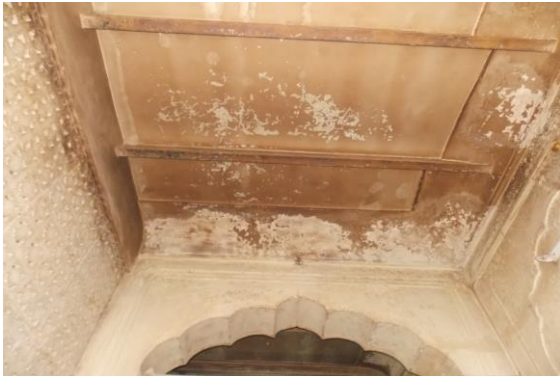
Photo 197

Peeling of Plaster on Roof of Room No. 10 of Temple Shri Anand Bihari Ji, First Floor

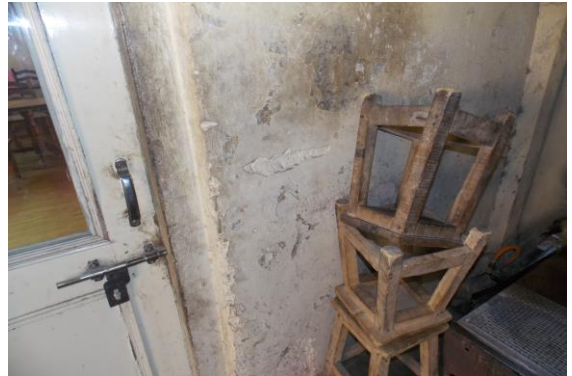
Photo 198

Peeling of Plaster on Wall No. 1 of Room No. 10 of Temple Shri Anand Bihari Ji, First Floor

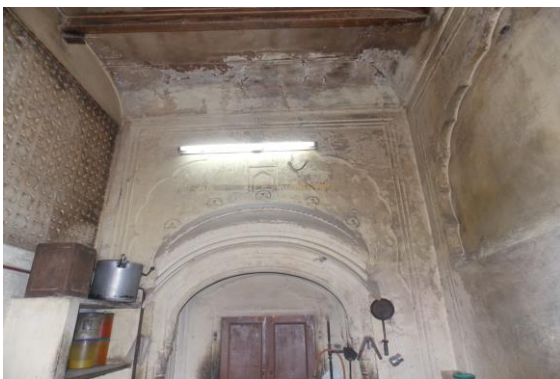
Photo 199

Peeling of Plaster on Wall No. 4 of Room No. 10 of Temple Shri Anand Bihari Ji, First Floor

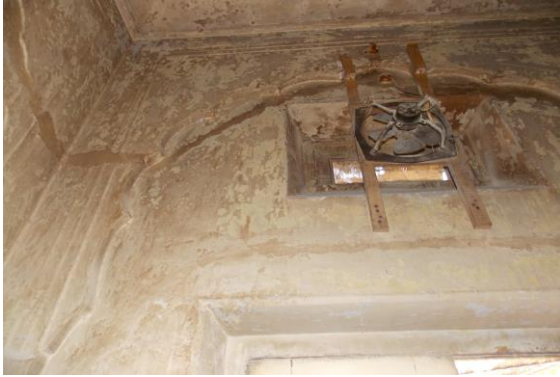
Photo 201

Peeling of Plaster on Wall No. 3 of Room No. 10 of Temple Shri Anand Bihari Ji, First Floor

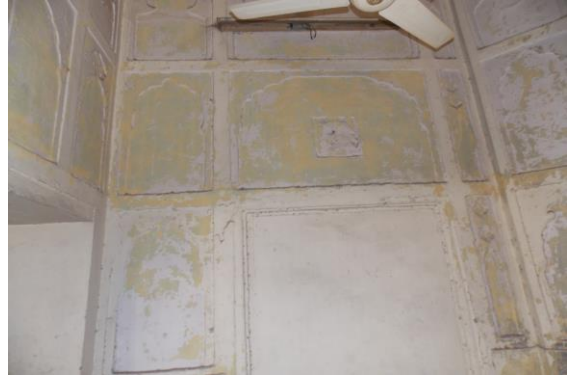
Photo 202

Peeling of Plaster on Wall No. 1 of Hall No. 1 of Temple Shri Anand Bihari Ji, First Floor

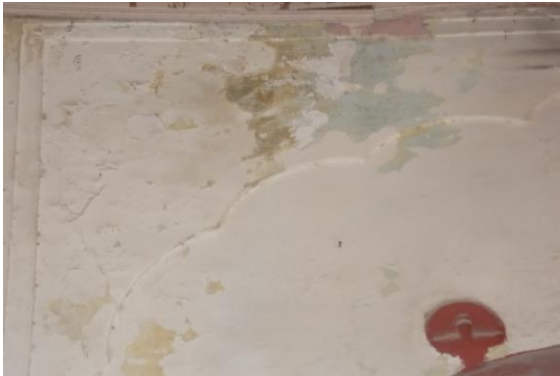
Photo 203

Peeling of Plaster on Wall No. 4 of Hall No. 1 of Temple Shri Anand Bihari Ji, First Floor

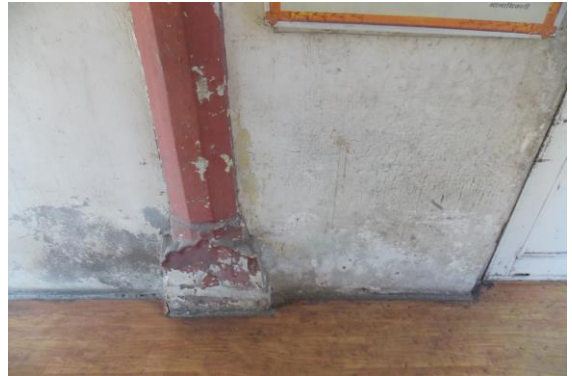
Photo 204

Peeling of Plaster on Wall No. 2 of Hall No. 1 of Temple Shri Anand Bihari Ji, First Floor

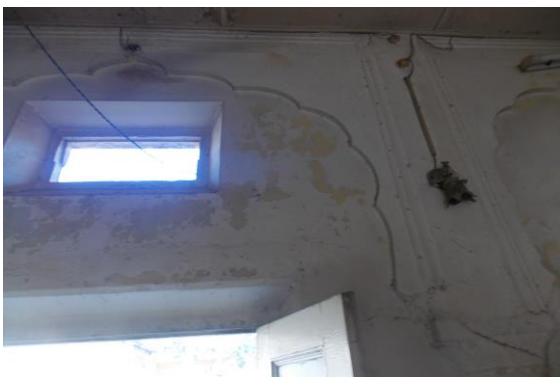
Photo 205

Peeling of Plaster on Wall No. 3 of Hall No. 1 of Temple Shri Anand Bihari Ji, First Floor

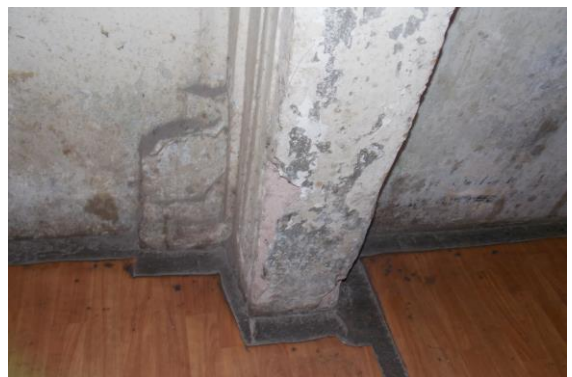
Photo 206

Peeling of Plaster on Wall No. 3 of Hall No. 1 of Temple Shri Anand Bihari Ji, First Floor

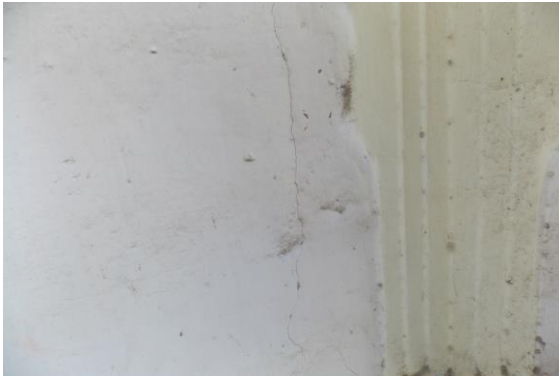
Photo 207

Peeling of Plaster on Wall No. 4 of Hall No. 1 of Temple Shri Anand Bihari Ji, First Floor

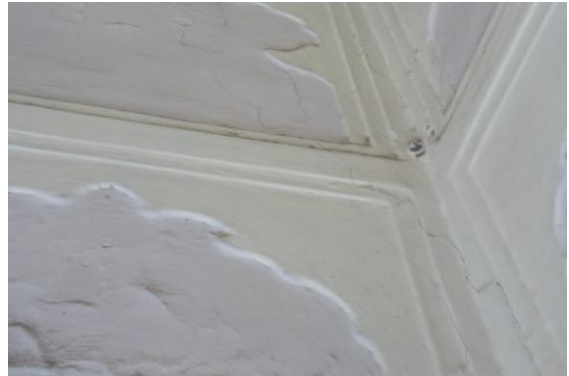
Photo 208

Peeling of Plaster on Wall No. 4 of Hall No. 1 of Temple Shri Anand Bihari Ji, First Floor

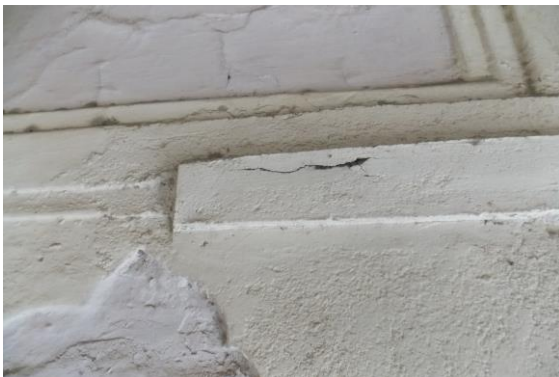
Photo 209

Peeling of Plaster on Wall No. 4 of Hall No. 2 of Temple Shri Anand Bihari Ji, First Floor

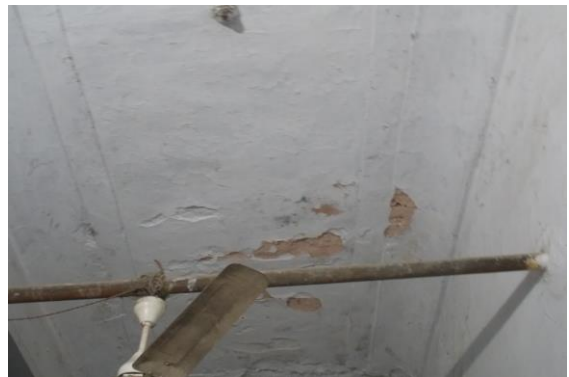
Photo 210

Peeling of Plaster on Roof of Hall No. 2 of Temple Shri Anand Bihari Ji, First Floor

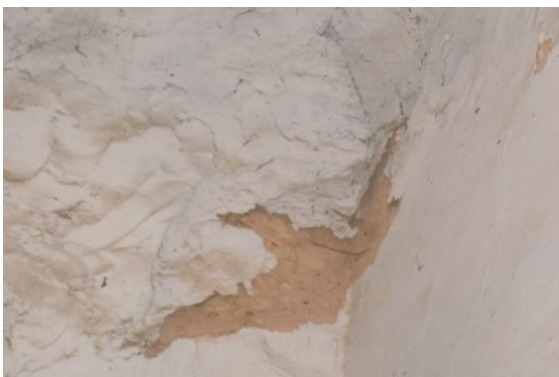
Photo 211

Peeling of Plaster on Wall No. 2 & 3 of Hall No. 2 of Temple Shri Anand Bihari Ji, First Floor

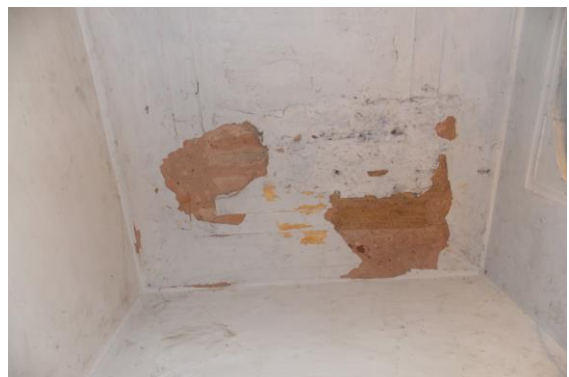
Photo 212

Peeling of Plaster on Roof of Hall No. 2 of Temple Shri Anand Bihari Ji, First Floor

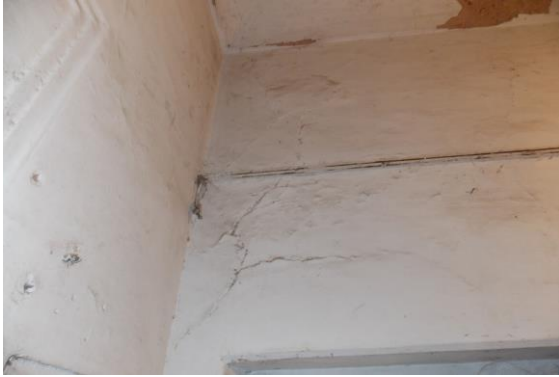
Photo 213

Peeling of Plaster on Wall No. 1 of Hall No. 2 of Temple Shri Anand Bihari Ji, First Floor

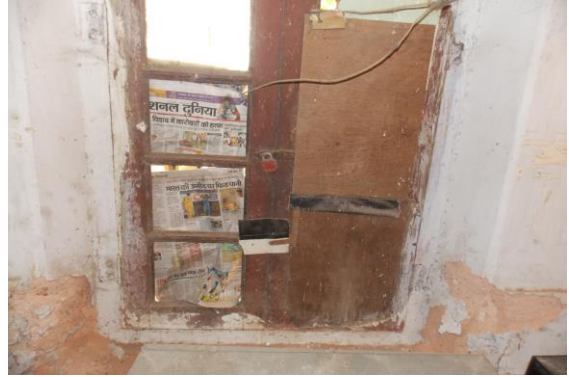
Photo 214

Peeling of Plaster on Wall No. 1 of Hall No. 2 of Temple Shri Anand Bihari Ji, First Floor

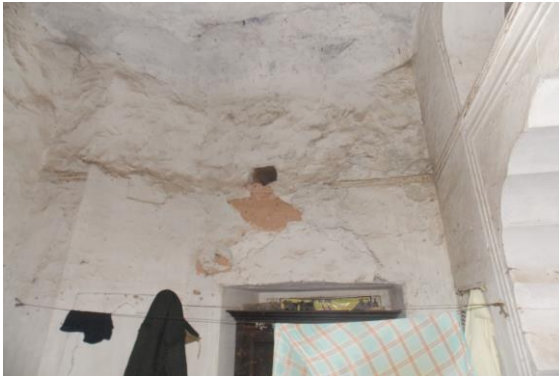
Photo 215

Peeling of Plaster on Wall No. 2 of Hall No. 2 of Temple Shri Anand Bihari Ji, First Floor

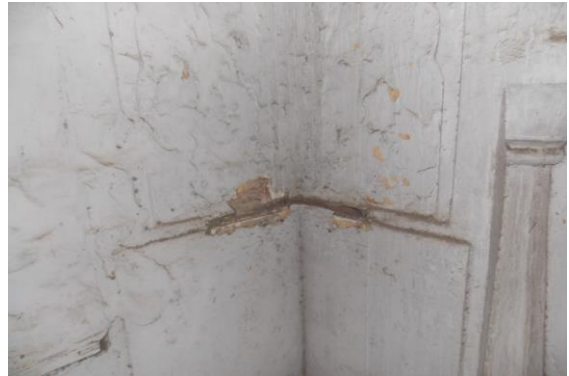
Photo 216

Peeling of Plaster on Wall No. 1 & 4 of Hall No. 2 of Temple Shri Anand Bihari Ji, First Floor

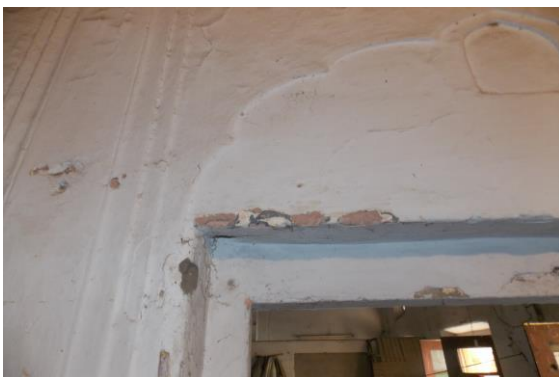
Photo 217

Peeling of Plaster on Wall No. 3 of Hall No. 2 of Temple Shri Anand Bihari Ji, First Floor

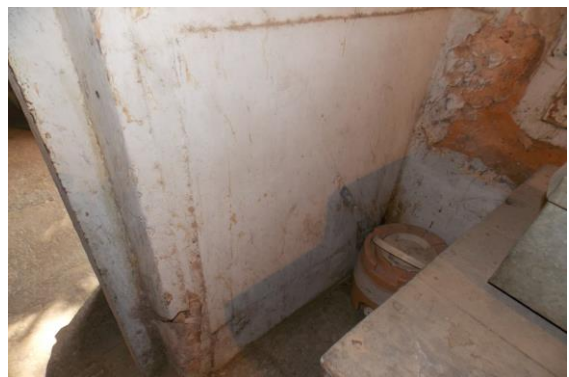
Photo 218

Peeling of Plaster on Wall No. 3 of Hall No. 2 of Temple Shri Anand Bihari Ji, First Floor

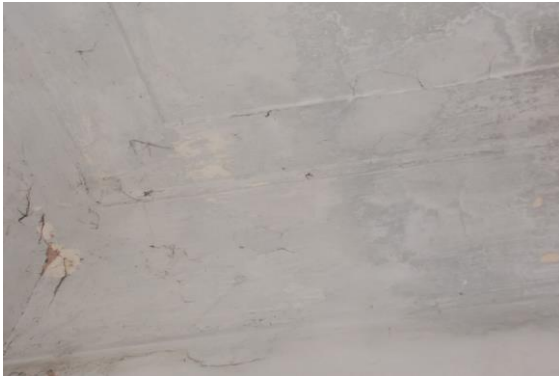
Photo 219

Dampness/Seepage on Roof of Hall No. 3 of Temple Shri Anand Bihari Ji, First Floor

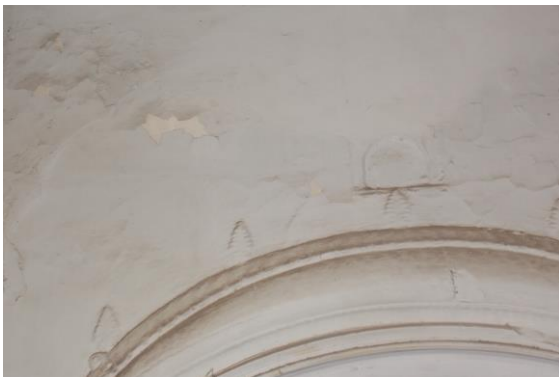
Photo 220

Dampness/Seepage on Roof of Hall No. 3 of Temple Shri Anand Bihari Ji, First Floor

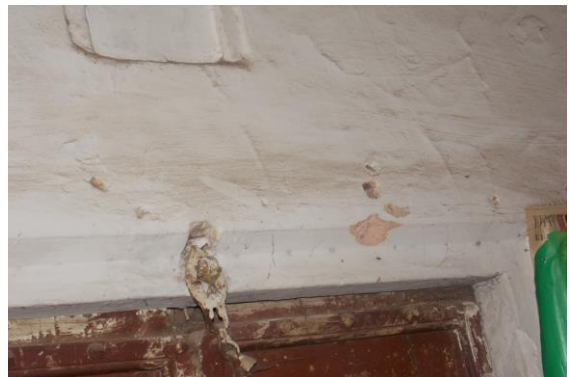
Photo 221

Peeling of Plaster on Wall No. 4 of Hall No. 3 of Temple Shri Anand Bihari Ji, First Floor

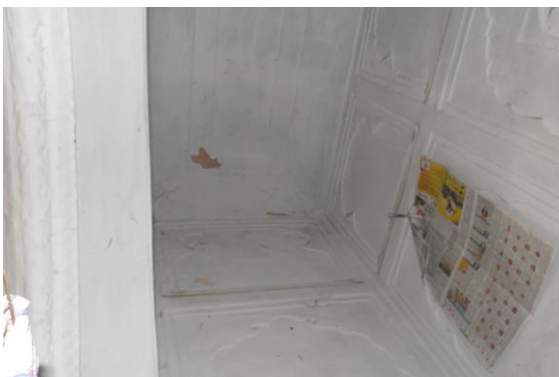
Photo 222

Peeling of Plaster on Wall No. 1 of Hall No. 3 of Temple Shri Anand Bihari Ji, First Floor

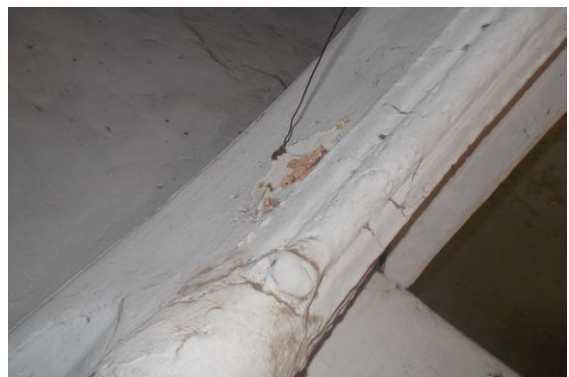
Photo 223

Peeling of Plaster on Roof of Hall No. 3 of Temple Shri Anand Bihari Ji, First Floor

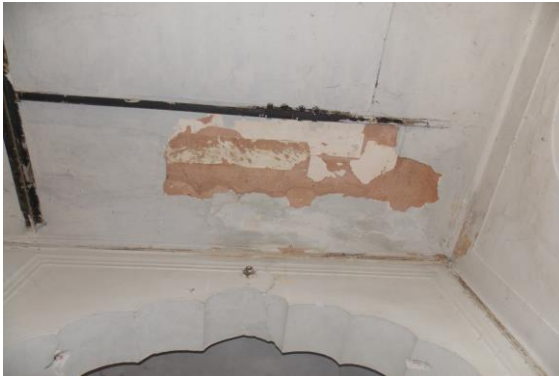
Photo 224

Peeling of Plaster on Wall No. 3 of Hall No. 3 of Temple Shri Anand Bihari Ji, First Floor

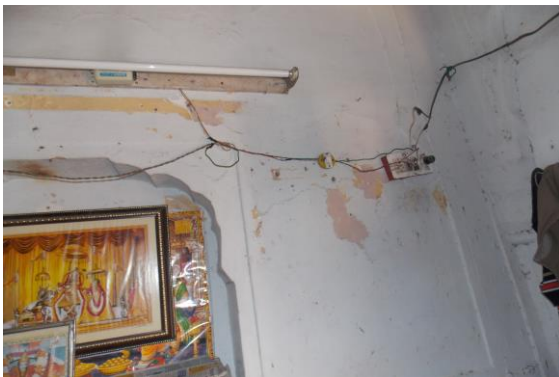
Photo 226

Peeling of Plaster on Wall No. 1 of Hall No. 4 of Temple Shri Anand Bihari Ji, First Floor

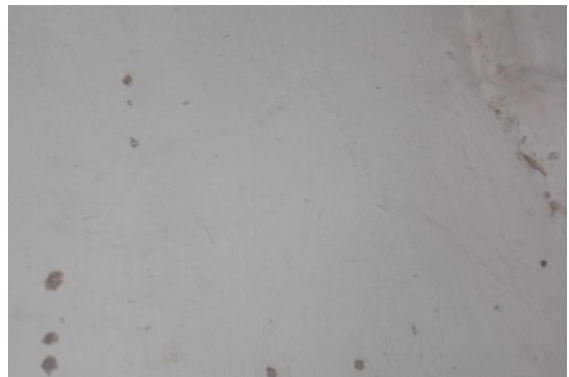
Photo 227

Peeling of Plaster on Wall No. 2 of Hall No. 4 of Temple Shri Anand Bihari Ji, First Floor

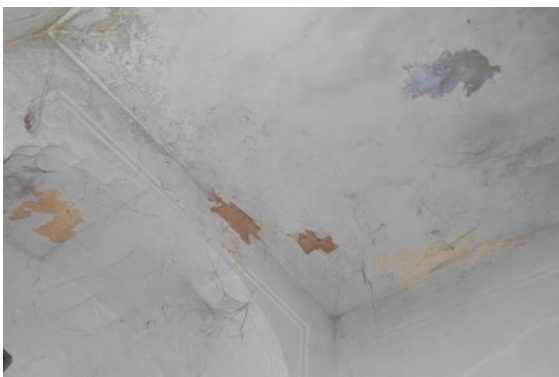
Photo 228

Peeling of Plaster on Wall No. 3 of Hall No. 4 of Temple Shri Anand Bihari Ji, First Floor

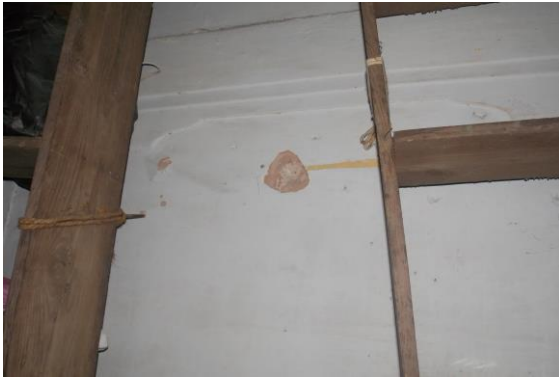
Photo 230

Dampness/Seepage on Roof, Wall No. 1 & 3 of Room No. 11 of Temple Shri Anand Bihari Ji, First Floor

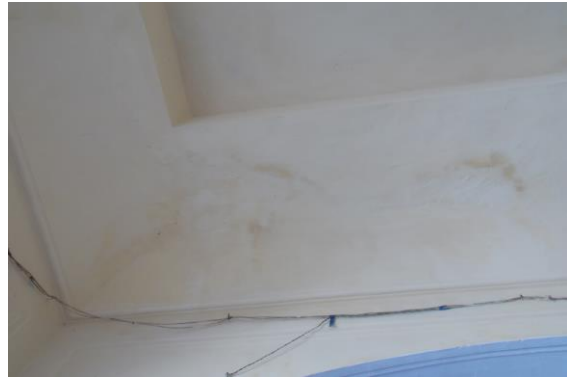
Photo 231

Peeling of Plaster on Wall No. 2 of Room No. 11 of Temple Shri Anand Bihari Ji, First Floor

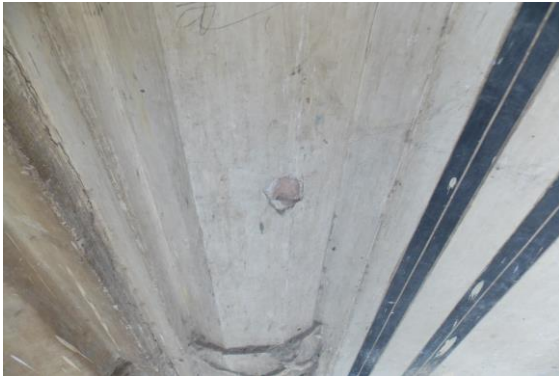
Photo 232

Dampness/Seepage on Roof & Wall No. 1 of Varanda No.1 of First Floor

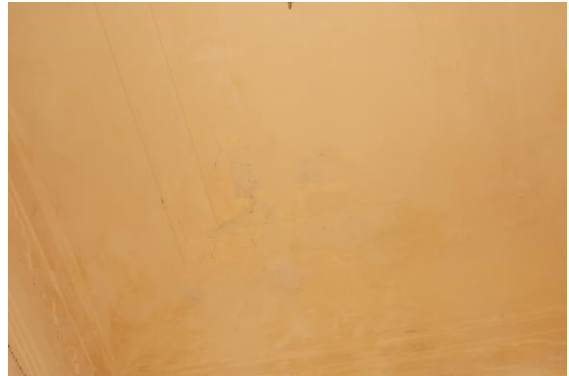
Photo 233

Peeling of Plaster on Wall No. 4 of Varanda No.1 of First Floor

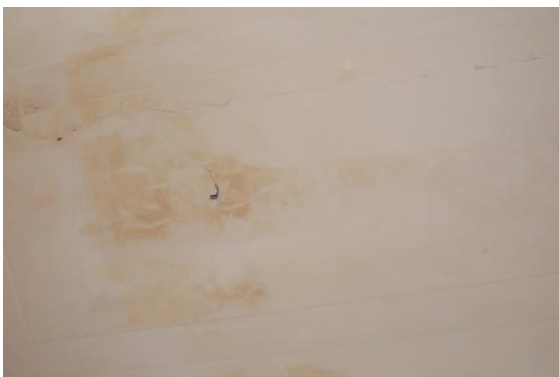
Photo 234

Dampness/Seepage on Roof of Passage No.1 of First Floor

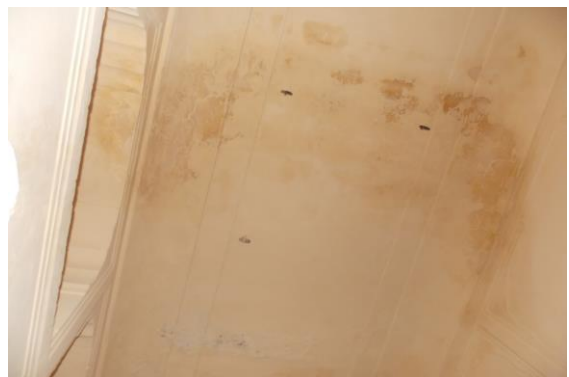
Photo 235

Dampness/Seepage on Roof of Passage No.1 of First Floor

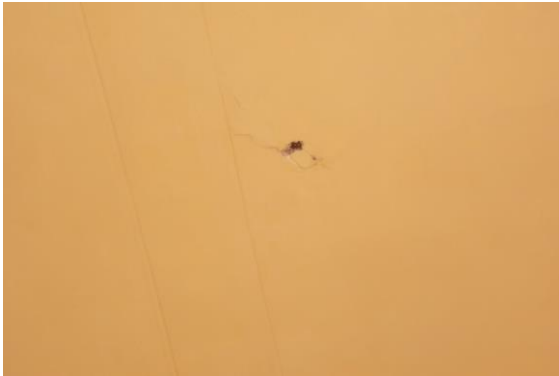
Photo 236

Dampness/Seepage on Roof of Varanda No.2 of First Floor

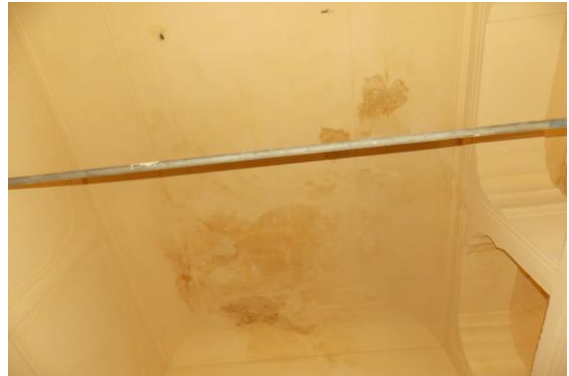
Photo 237
Peeling of Plaster on Roof of Passage No.3 of First Floor

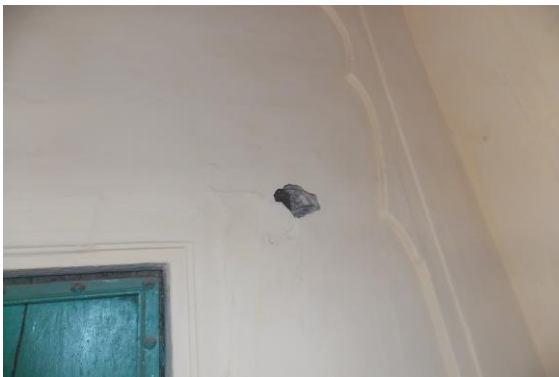
Photo 238
Dampness/Seepage on Roof of Varanda No.3 of First Floor

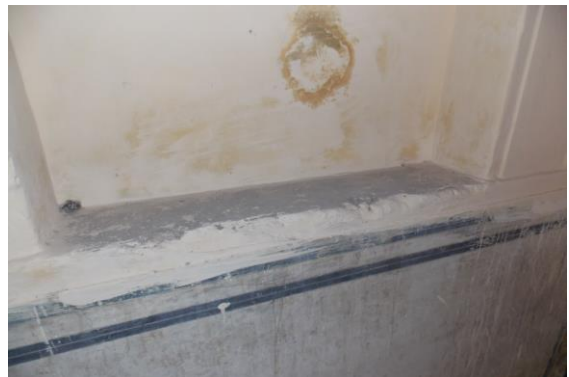
Photo 239
Peeling of Plaster on Wall No. 1 of Varanda No.3 of First Floor

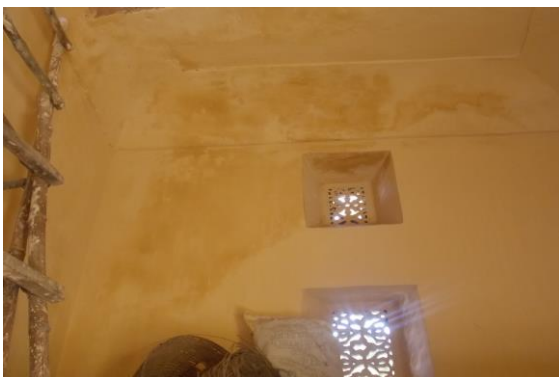
Photo 240
Peeling of Plaster on Wall No. 4 of Varanda No.3 of First Floor

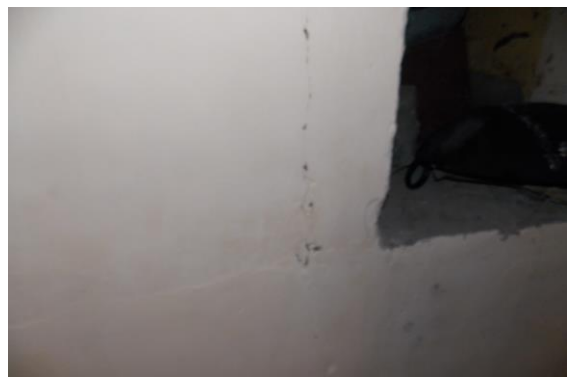
Photo 241
Dampness/Seepage on Roof & Wall No. 4 of Hall No. 5 of Temple Shri Anand Bihari Ji, First Floor

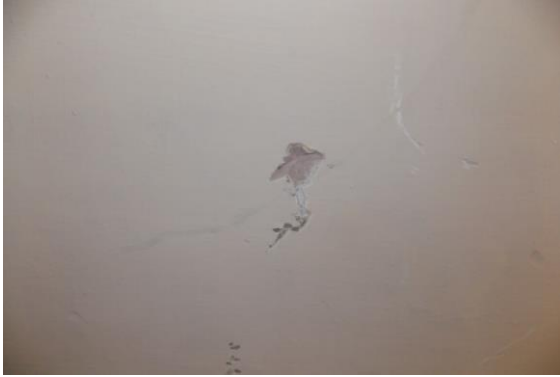
Photo 242
Peeling of Plaster on Wall No. 1 of Passage No.6 of First Floor

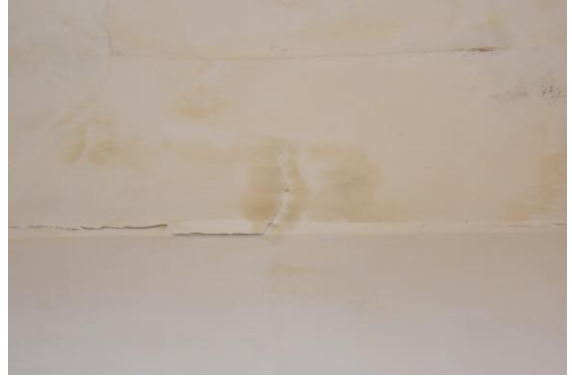
Photo 243
Peeling of Plaster on Wall No. 3 of Passage No.5 of First Floor

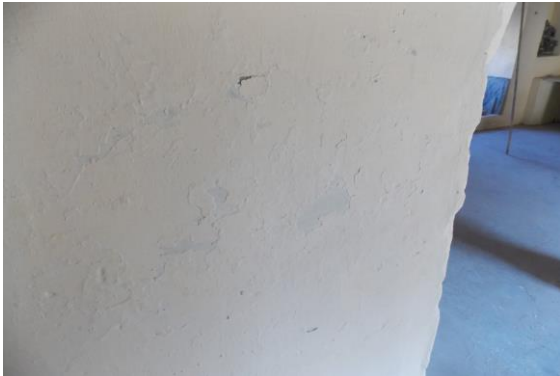
Photo 244
Peeling of Plaster on Wall No. 3 & Roof of Passage No.5 of First Floor

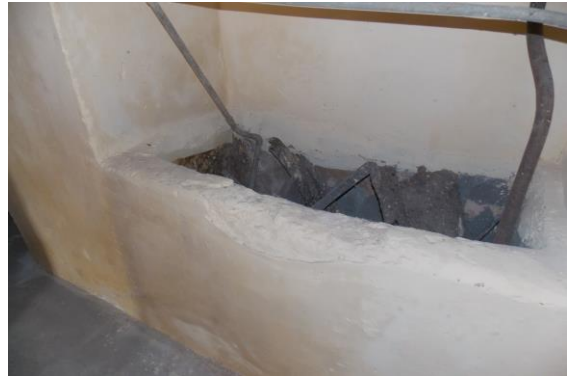
Photo 245
Peeling of Plaster on Wall No. 1 of Passage No.5 of First Floor

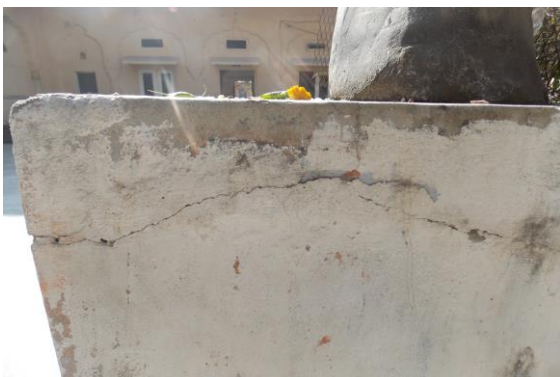
Photo 246
Peeling of Plaster on Wall No. 1 of Hall No. 5 of Temple Shri Anand Bihari Ji, First Floor

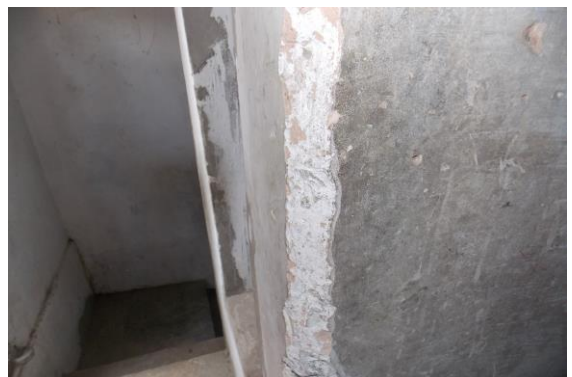
Photo 247
Peeling of Plaster on Rightside View of Temple Shri Anand Bihari Ji of First Floor

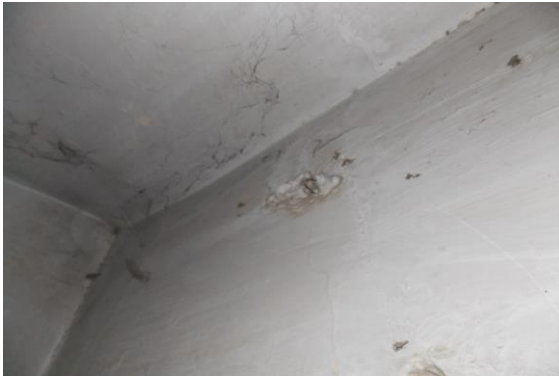
Photo 248
Peeling of Plaster on Wall No. 4 of Passage No.7 of First Floor

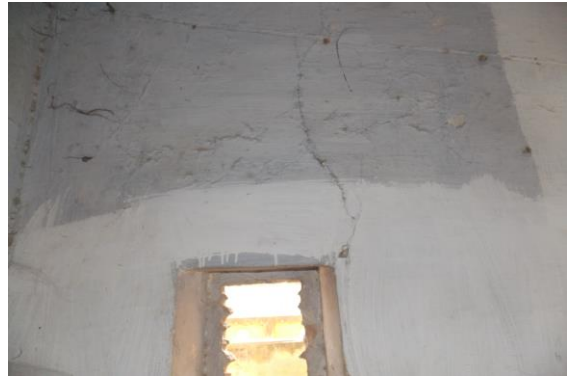
Photo 249
Peeling of Plaster on Wall No. 3 of Passage No.7 of First Floor

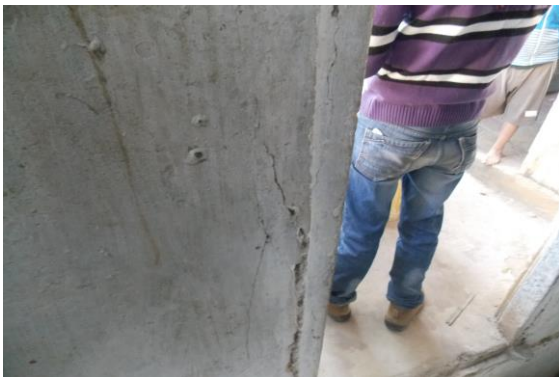
Photo 250
Peeling of Plaster on Wall No. 1 of Passage No.7 of First Floor

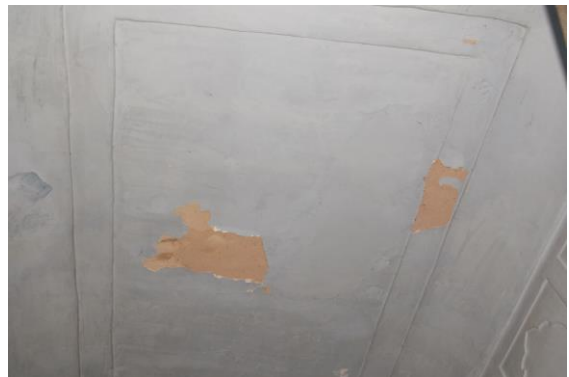
Photo 251
Peeling of Plaster on Wall No. 1 of Passage No.7 of First Floor

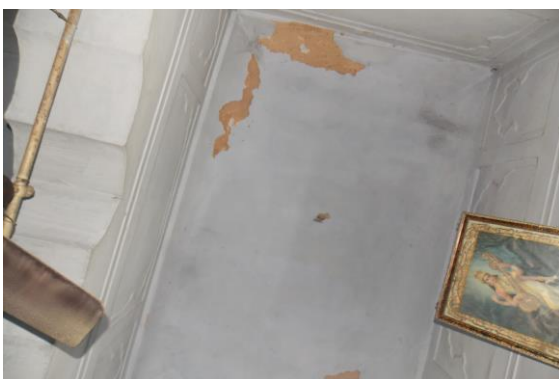
Photo 252
Peeling of Plaster on Roof of Hall No. 1 of Part B - Temple Shri Anand Bihari Ji, First Floor

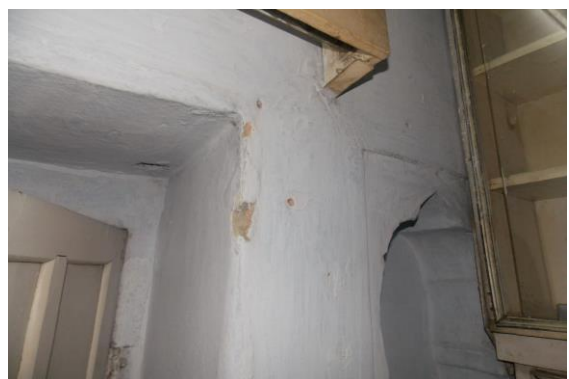
Photo 253
Peeling of Plaster on Roof of Hall No. 1 of Part B - Temple Shri Anand Bihari Ji, First Floor

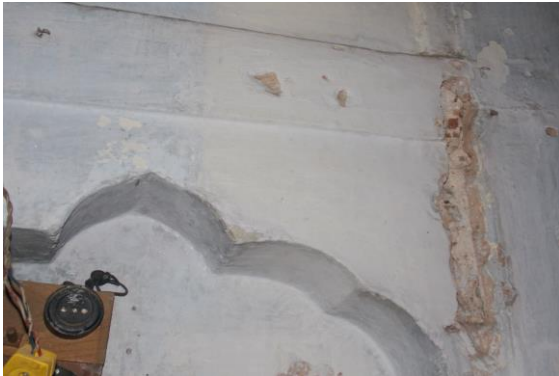
Photo 254
Peeling of Plaster on Wall No. 3 of Hall No. 1 of Part B - Temple Shri Anand Bihari Ji, First Floor

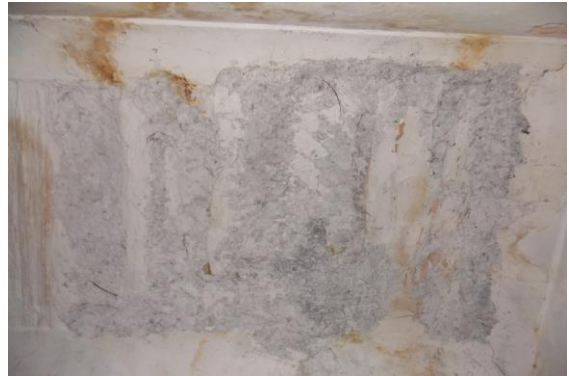
Photo 255

Peeling of Plaster on Wall No. 2 of Hall No. 1 of Part B - Temple Shri Anand Bihari Ji, First Floor

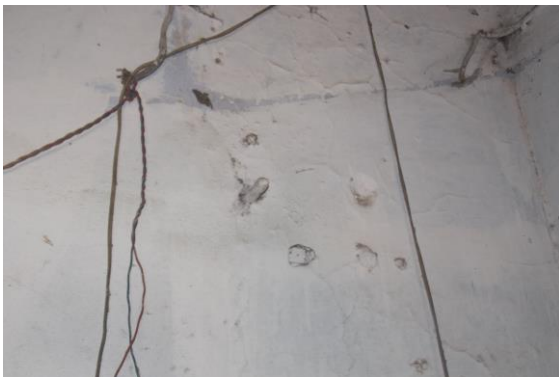
Photo 256

Dampness/Seepage on Roof of Varanda No.1 of First Floor

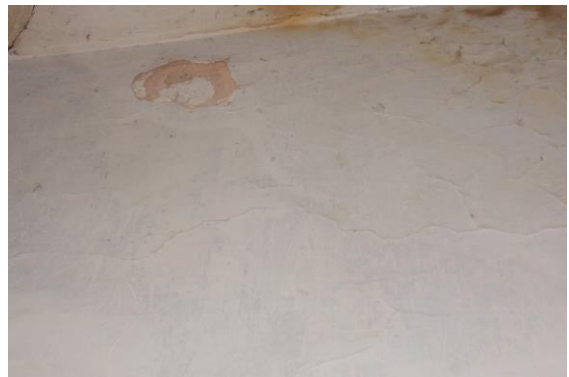
Photo 257

Peeling of Plaster on Wall No. 4 of Varanda No.1 of First Floor

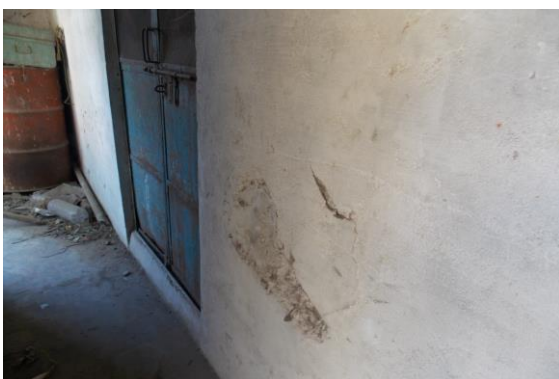
Photo 258

Peeling of Plaster on Wall No. 3 of Varanda No.1 of First Floor

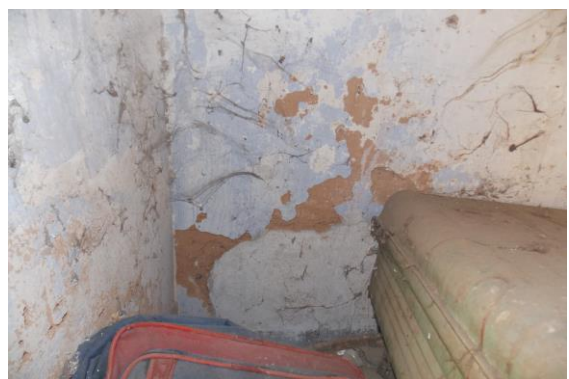
Photo 260

Peeling of Plaster on Wall No. 1 of Varanda No.1 of First Floor

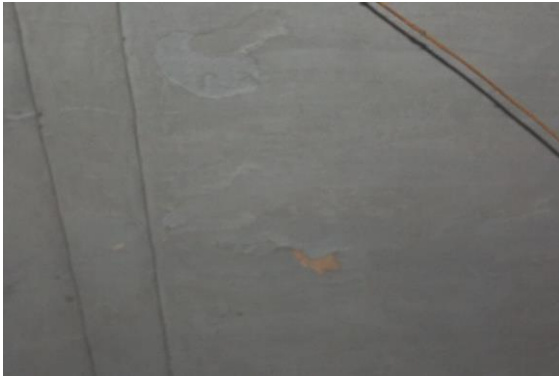
Photo 261

Peeling of Plaster on Roof of Room No. 2 of Part B - Temple Shri Anand Bihari Ji, First Floor

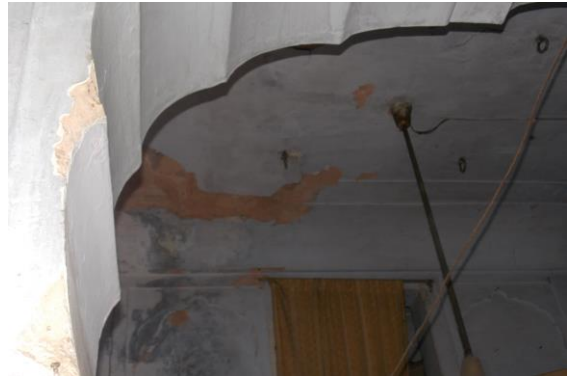
Photo 262

Dampness/Seepage on Wall No. Roof & 6 of Hall No. 1 of Part B - Temple Shri Anand Bihari Ji, First Floor

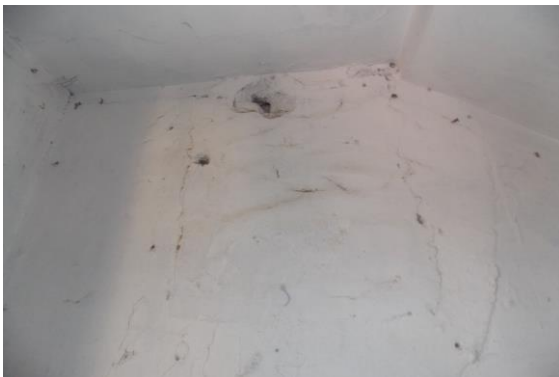
Photo 263

Peeling of Plaster on Wall No. 2 of Staircase Ground Floor To First Floor of Ground Floor

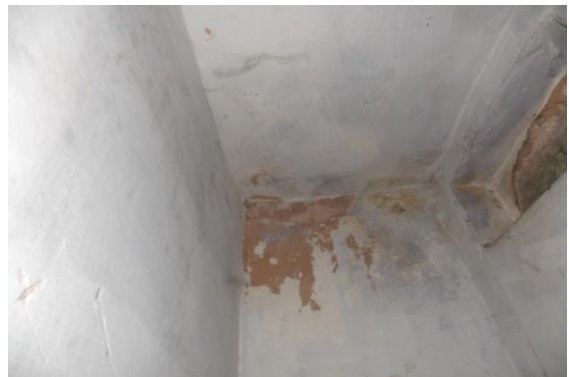
Photo 264

Peeling of Plaster on Wall No. 3 of Staircase Ground Floor To First Floor of Ground Floor

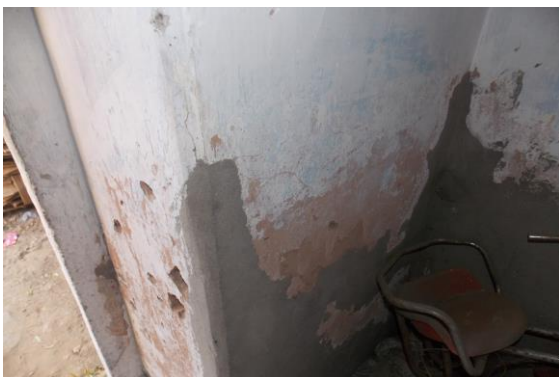
Photo 265

Peeling of Plaster on Wall No. 1 & 3 of Staircase Ground Floor To First Floor of Ground Floor

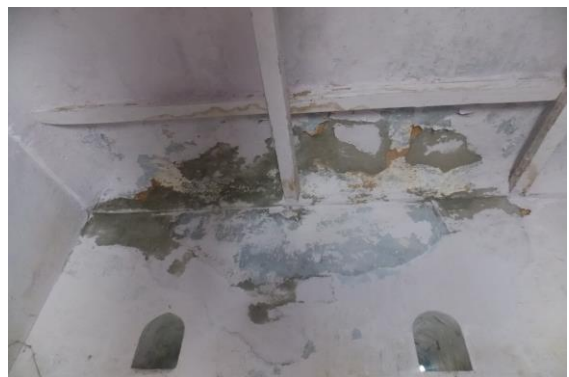
Photo 266

Dampness/Seepage on Wall No. 1 & Roof of Hanuman temple of Ground Floor

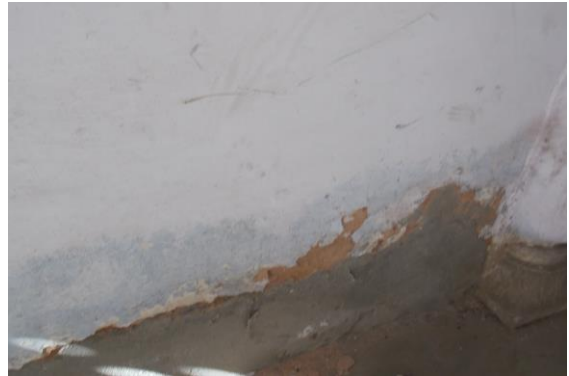
Photo 268
Peeling of Plaster on Wall No. 1 of Hanuman temple of Ground Floor

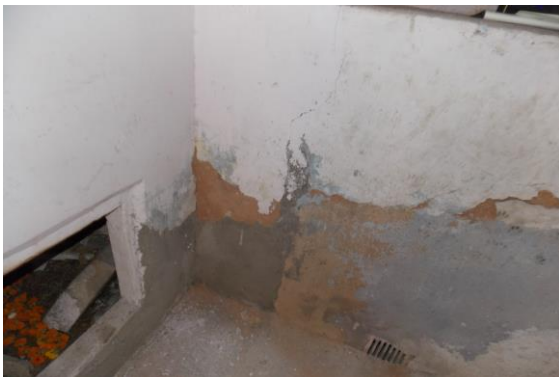
Photo 269
Peeling of Plaster on Wall No. 1 & 4 of Hanuman temple of Ground Floor

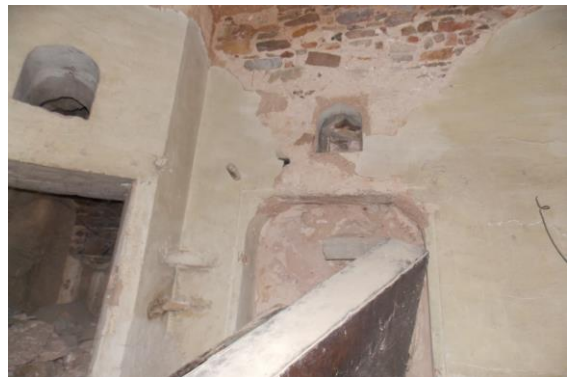
Photo 270
Damaged Portion on Wall No. 4 of Store of Ground Floor

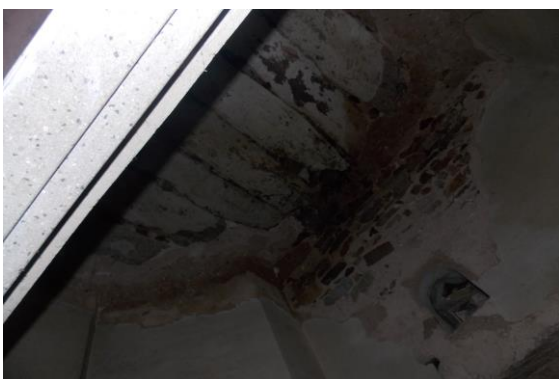
Photo 271
Damaged Portion on Roof of Store of Ground Floor

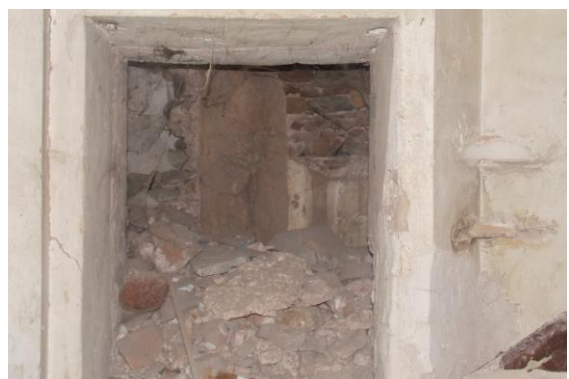
Photo 272
Damaged Portion on Tomb Area of of Ground Floor

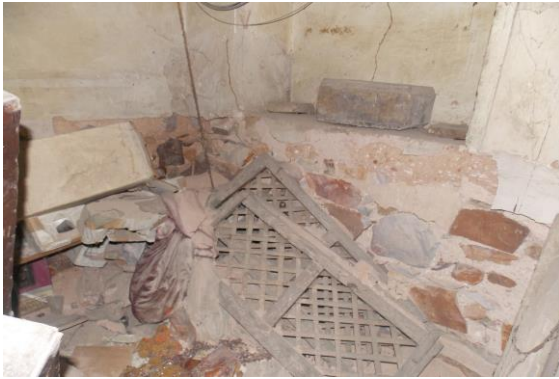
Photo 273
Damaged Portion on Wall No. 2 of Store of Ground Floor

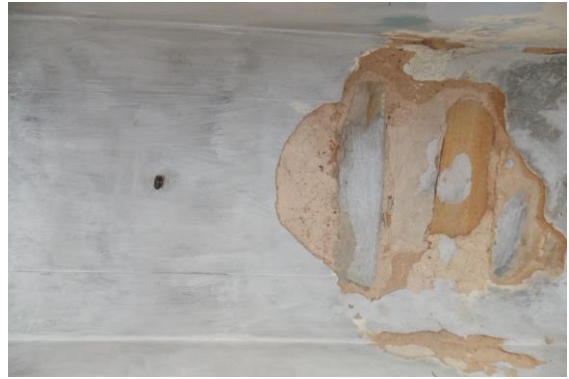
Photo 274
Peeling of Plaster on Roof of Varanda No.2 of Ground Floor

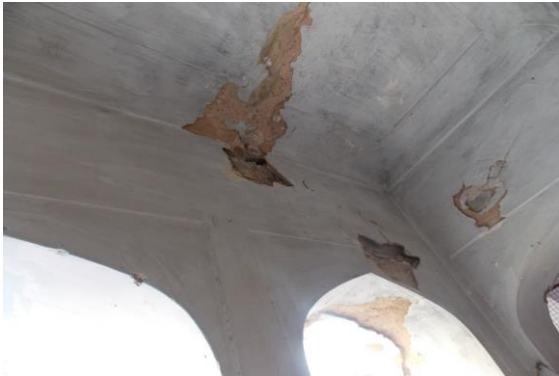
Photo 275
Peeling of Plaster on Wall No. 3 & Roof of Varanda No.2 of Ground Floor

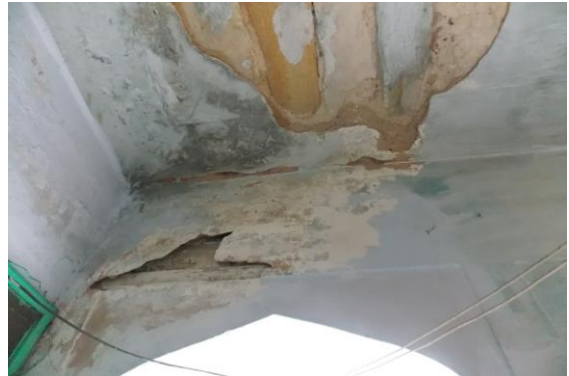
Photo 276
Peeling of Plaster on Wall No. 3 & Roof of Varanda No.2 of Ground Floor

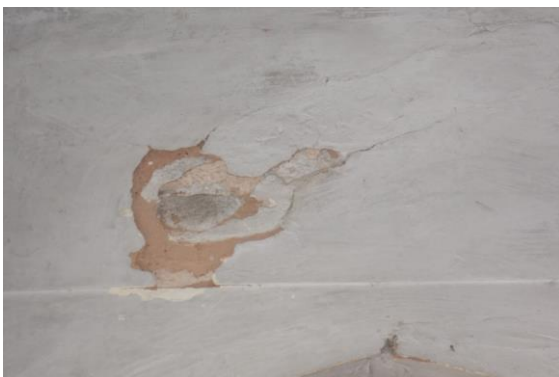
Photo 277
Peeling of Plaster on Wall No. 1 of Varanda No.2 of Ground Floor

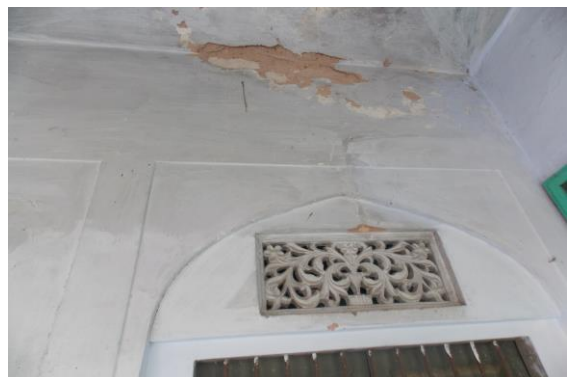
Photo 278
Peeling of Plaster on Wall No. 4 of Varanda No.2 of Ground Floor
