Pre Building Condition Survey Report

Name and Address of Structure :	Badi Chopar Station Area
---------------------------------	--------------------------

Name of the Project	Contract JMRC-UG1B “Design and Construction of Tunnel between Chandpole and Badi Chouper and reverse line by Shield TBM, Underground Metro Stations at Choti Chouper and Badi Chouper by Cut and Cover Methods on East West Corridor of Jaipur Metro Rail Corporation Limited .”	
Owner :

Pre - Condition Building Survey for Construction of Underground Stations from Chandpole to Bari Chouper and reversal line

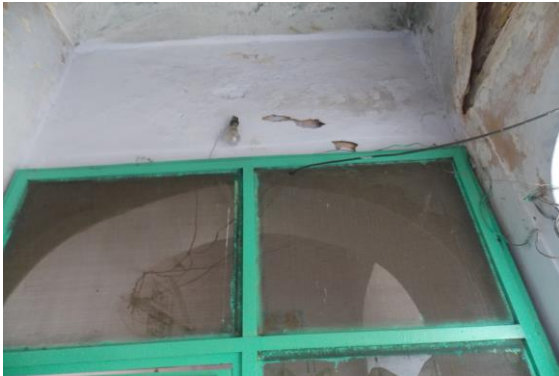
Photo 279

Peeling of Plaster on Wall No. 2 of Varanda No.2 of Ground Floor

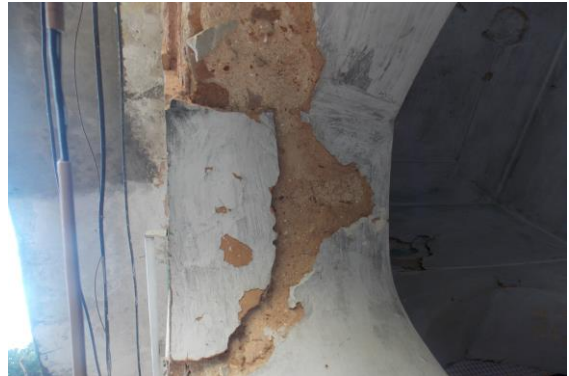
Photo 280

Peeling of Plaster on Gate Roof of Varanda No.2 of Ground Floor

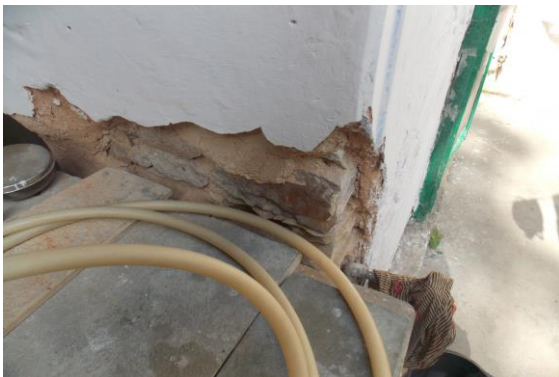
Photo 281

Peeling of Plaster on Wall No. 2 of Varanda No.2 of Ground Floor

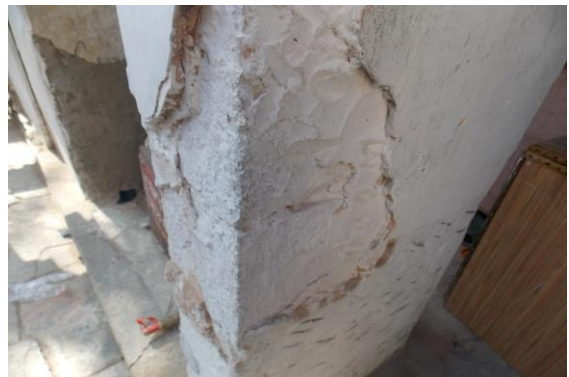
Photo 282

Peeling of Plaster on Column of Varanda No.2 of Ground Floor

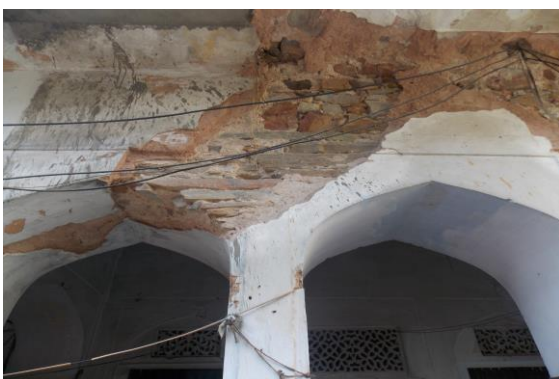
Photo 283

Peeling of Plaster on Wall No. 4 of Open sky of Ground Floor

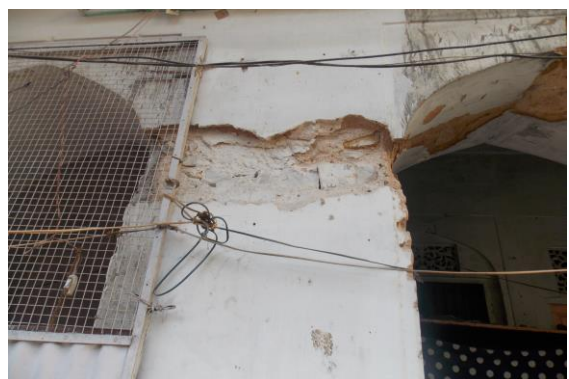
Photo 284

Peeling of Plaster on Wall No. 4 of Open sky of Ground Floor

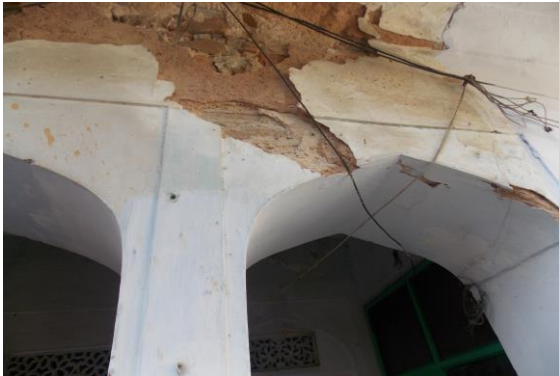
Photo 285

Peeling of Plaster on Wall No. 4 of Open sky of Ground Floor

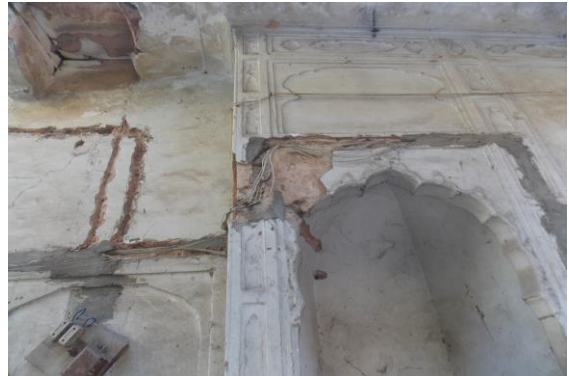
Photo 286

Peeling of Plaster on Wall No. 3 of Open sky of Ground Floor

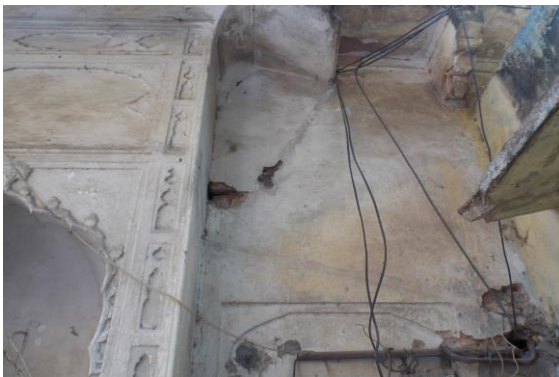
Photo 287

Peeling of Plaster on Wall No. 3 of Open sky of Ground Floor

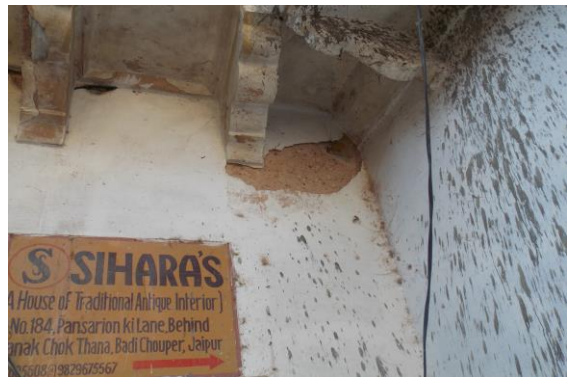
Photo 288

Peeling of Plaster on Wall No. 1 of Open sky of Ground Floor

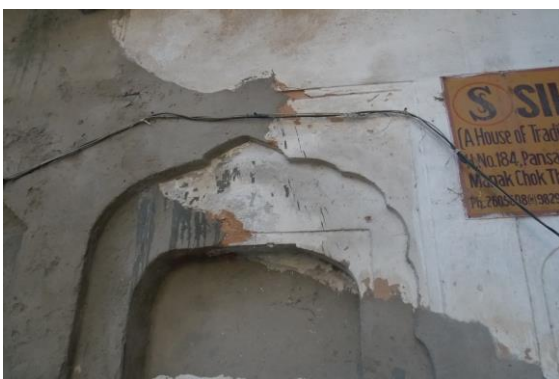
Photo 289

Peeling of Plaster on Wall No. 1 of Open sky of Ground Floor

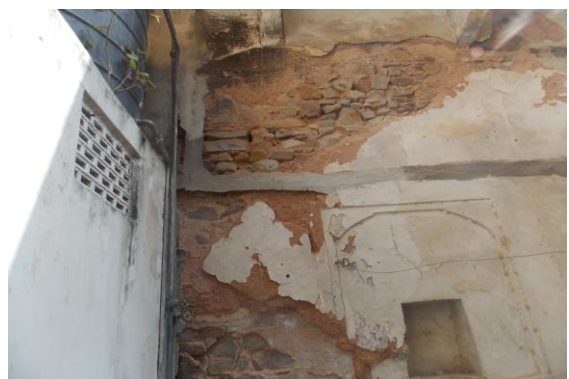
Photo 290

Peeling of Plaster on Wall No. 3 of Open sky of Ground Floor

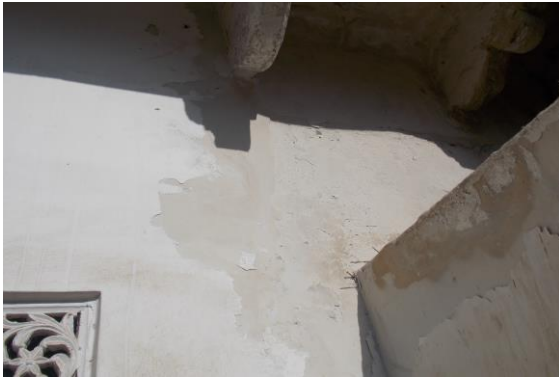
Photo 291
Peeling of Plaster on Wall No. 2 of Open sky of Ground Floor

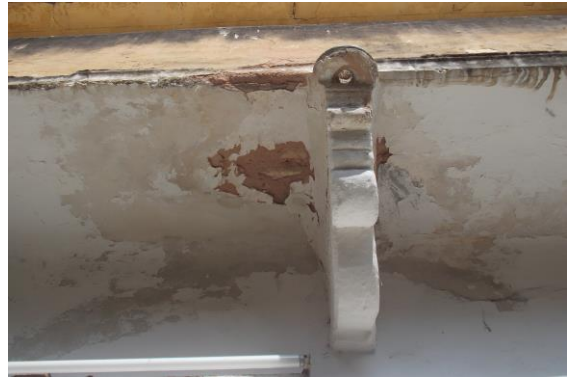
Photo 292
Peeling of Plaster on Sun Shade of Open sky of Ground Floor

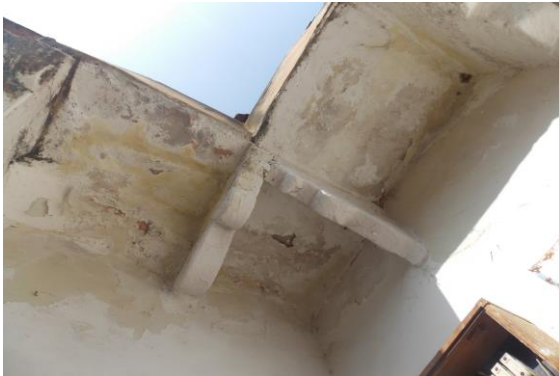
Photo 293
Peeling of Plaster on Sun Shade of Open sky of Ground Floor

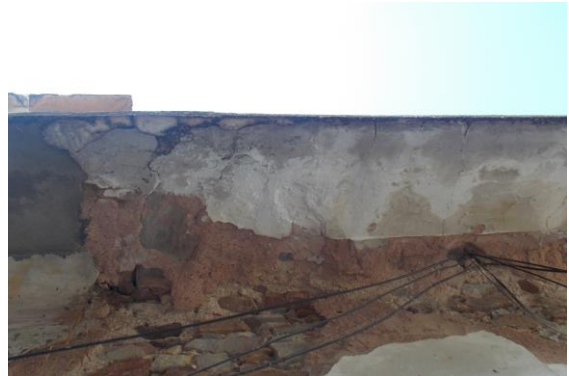
Photo 294
Peeling of Plaster on Wall No. 4 of Sun Shade, Open sky of Ground Floor

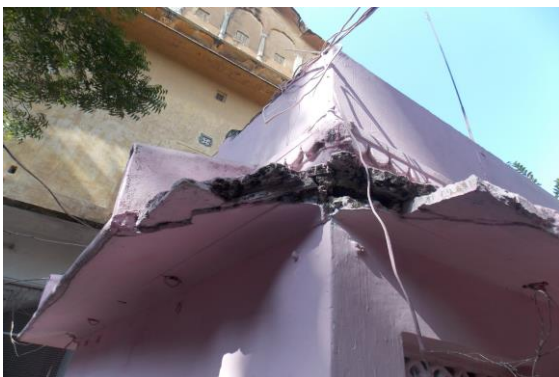
Photo 295
Damaged Portion on Sun Shade of Part B of Temple Shri Anand Bihari Ji of Ground Floor

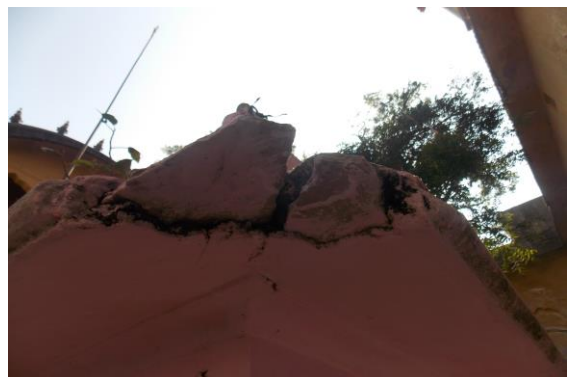
Photo 296
Damaged Portion on Sun Shade of Part B of Temple Shri Anand Bihari Ji of Ground Floor

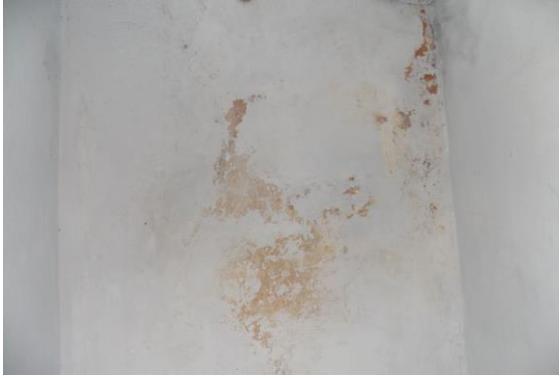
Photo 297

Dampness/Seepage on Wall No. 4 of Toilet No. 2 of Part B - Temple Shri Anand Bihari Ji, Ground Floor

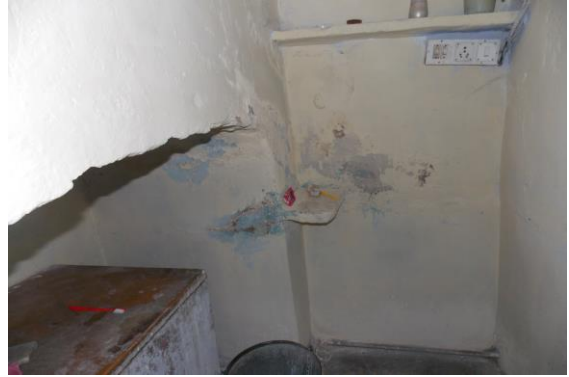
Photo 298

Dampness/Seepage on Wall No. 4 of Bathroom of Part B - Temple Shri Anand Bihari Ji, Ground Floor

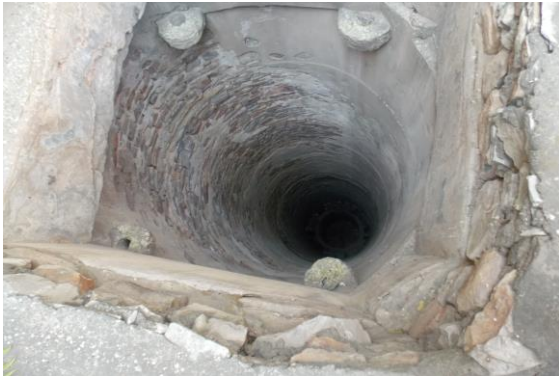
Photo 299

Peeling of Plaster on Well of Ground Floor

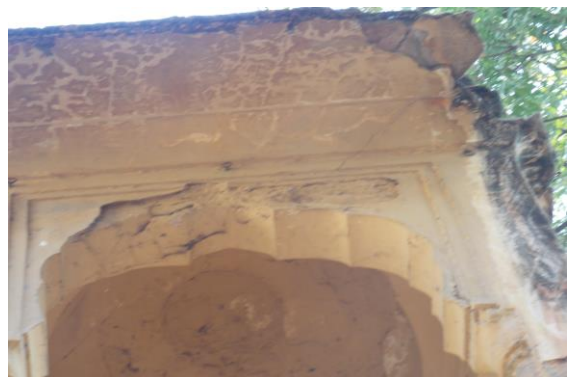
Photo 301

Peeling of Plaster on Part B of Temple Shri Anand Bihari Ji of Ground Floor

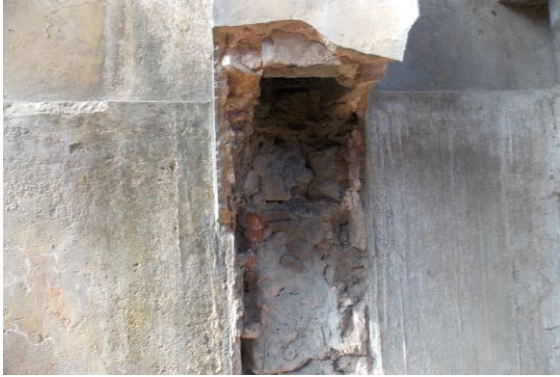
Photo 303

Damaged Portion on Column & Backside of Part B of Temple Shri Anand Bihari Ji of Ground Floor

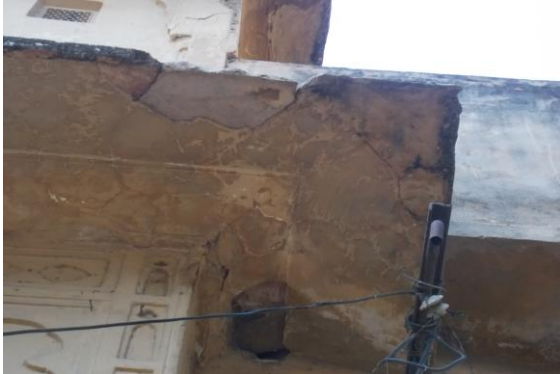
Photo 305

Damaged Portion on Sun Shade & At Gate of Part B of Temple Shri Anand Bihari Ji of Ground Floor

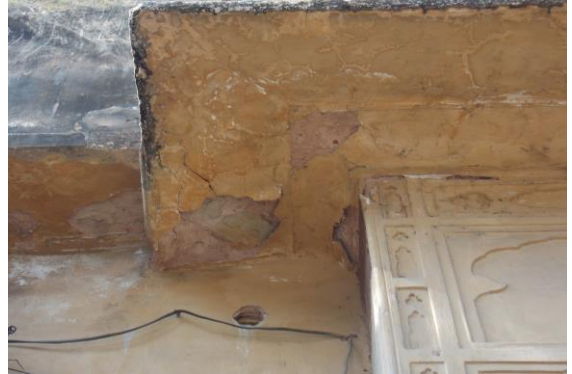
Photo 306

Peeling of Plaster on Sun Shade of Part B of Temple Shri Anand Bihari Ji of Ground Floor

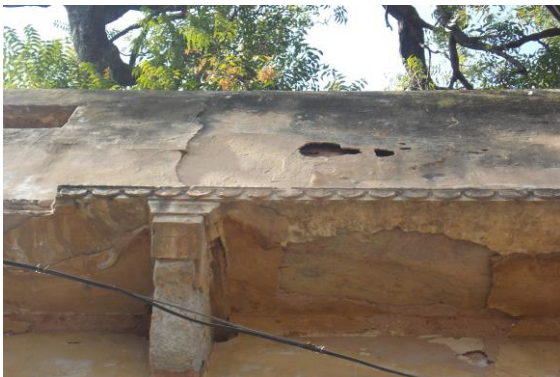
Photo 307

Peeling of Plaster on Parapet Wall of Part B of Temple Shri Anand Bihari Ji of First Floor

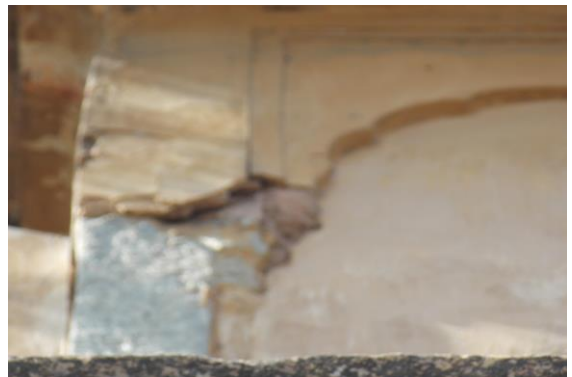
Photo 308

Peeling of Plaster on Minarates of Part B of Temple Shri Anand Bihari Ji of First Floor

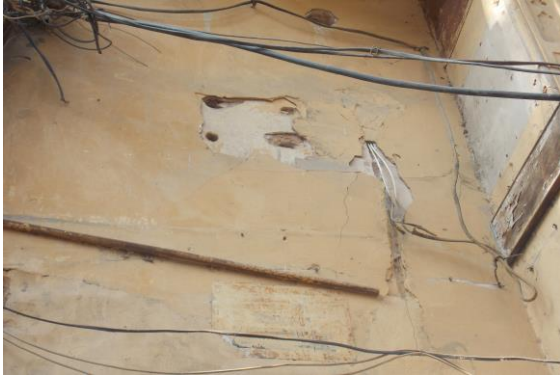
Photo 309

Peeling of Plaster on Minarates of Part B of Temple Shri Anand Bihari Ji of Ground Floor

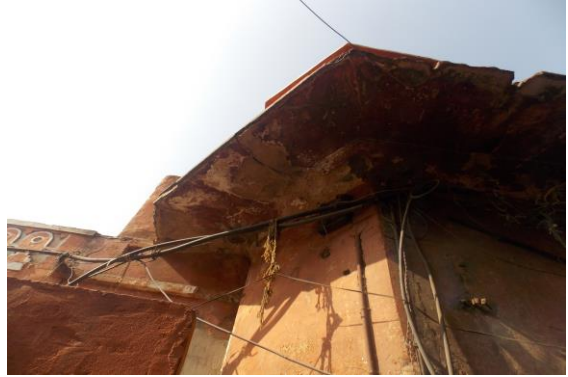
Photo 310

Peeling of Plaster on Rightside View of Part B of Temple Shri Anand Bihari Ji of Ground Floor

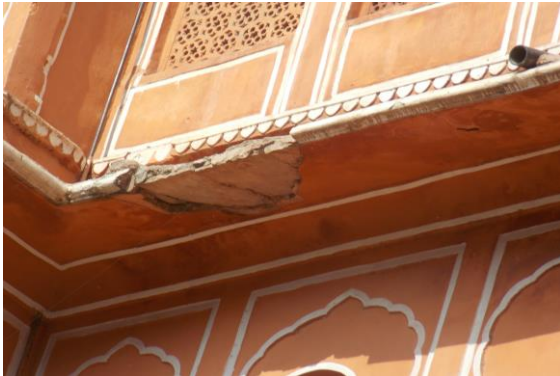
Photo 311

Peeling of Plaster on Sun Shade of Part B of Temple Shri Anand Bihari Ji of First Floor

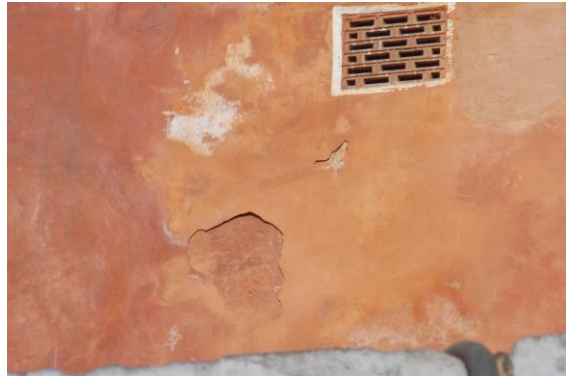
Photo 312

Peeling of Plaster on outer wall No.1 of Part B of Temple Shri Anand Bihari Ji of First Floor

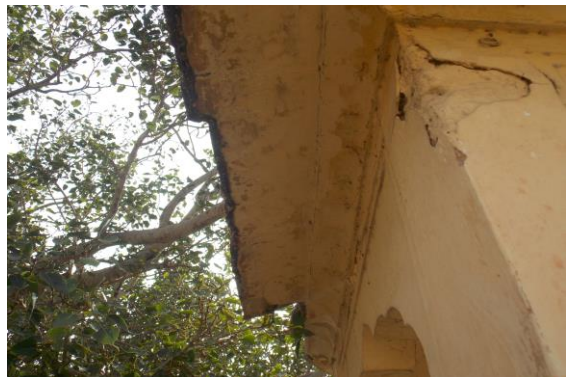
Photo 314

Damaged Portion on Sun shade of Part A+B of Temple Shri Anand Bihari Ji of Terrace

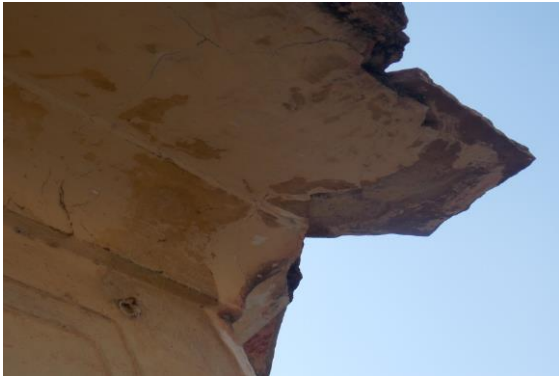
Photo 315

Damaged Portion on Sun shade of Part A+B of Temple Shri Anand Bihari Ji of Terrace

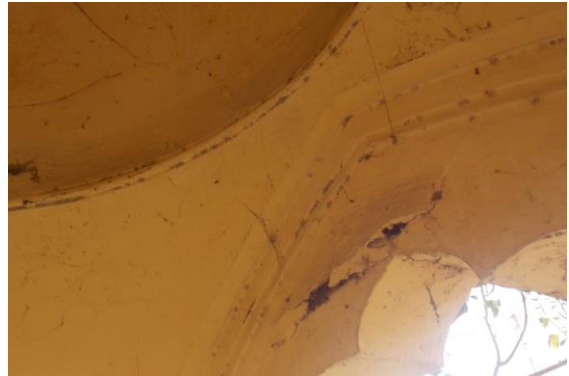
Photo 316

Peeling of Plaster on Wall No. 2 of Part A+B of Temple Shri Anand Bihari Ji of Terrace

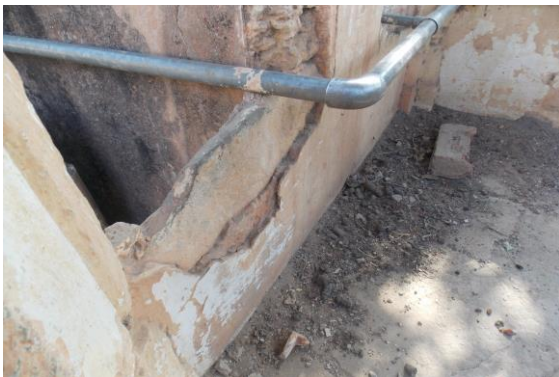
Photo 317

Peeling of Plaster on Wall No. 1 of Part A+B of Temple Shri Anand Bihari Ji of Terrace

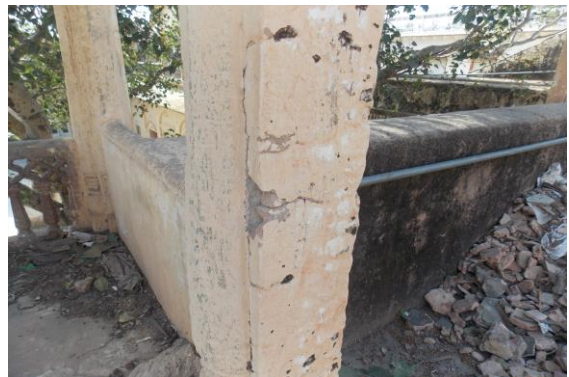
Photo 318

Peeling of Plaster on Minarates & External Wall of Part A+B of Temple Shri Anand Bihari Ji of Terrace

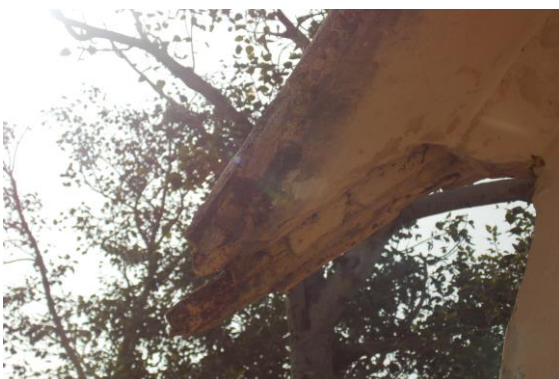
Photo 319

Damaged Portion on Sun Shade of Part A+B of Temple Shri Anand Bihari Ji of Terrace

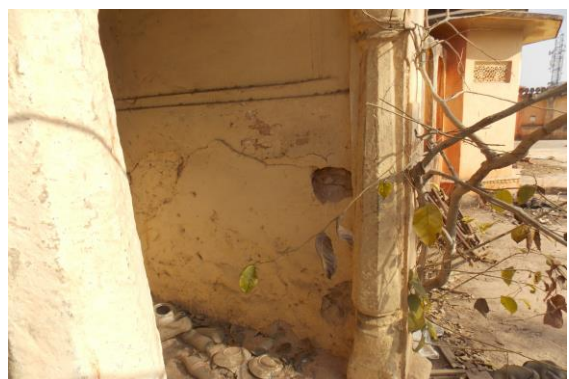
Photo 320

Peeling of Plaster on Wall No. 2 & Minarates of Part A+B of Temple Shri Anand Bihari Ji of Terrace

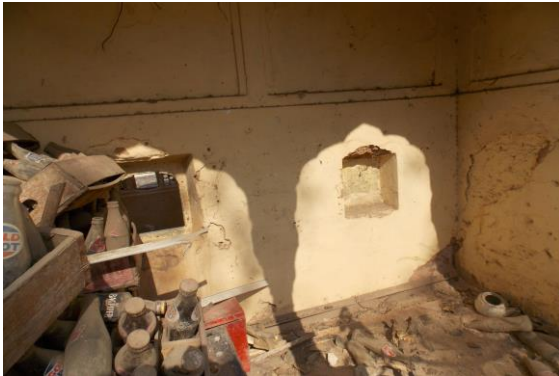
Photo 321

Peeling of Plaster on Wall No. 4 & Minarates of Part A+B of Temple Shri Anand Bihari Ji of Terrace

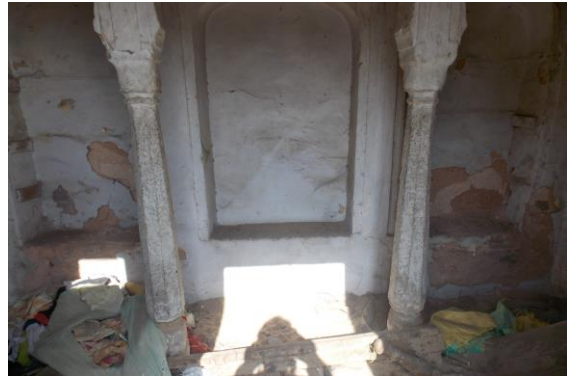
Photo 322

Peeling of Plaster on Wall No. 4 & Minarates No.3 of Part A+B of Temple Shri Anand Bihari Ji of Terrace

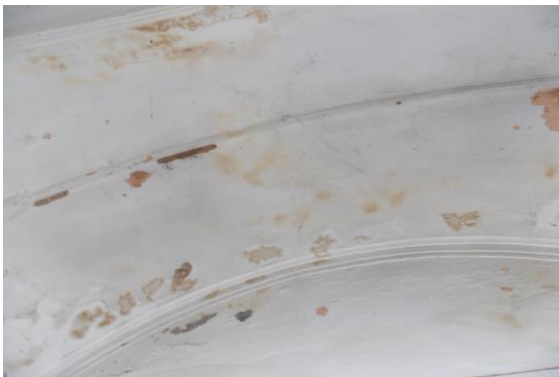
Photo 323

Peeling of Plaster on Roof & Minarates No.3 of Part A+B of Temple Shri Anand Bihari Ji of Terrace

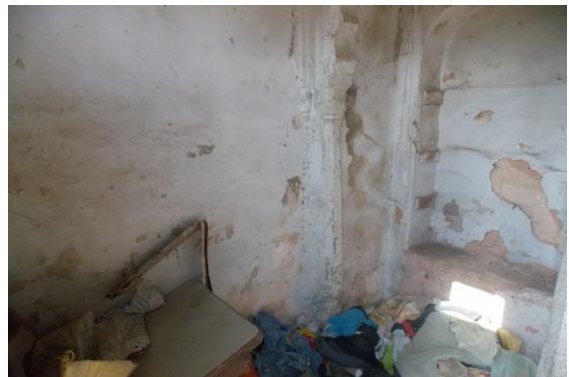
Photo 324

Peeling of Plaster on Wall No. 1 & Minarates No.3 of Part A+B of Temple Shri Anand Bihari Ji of Terrace

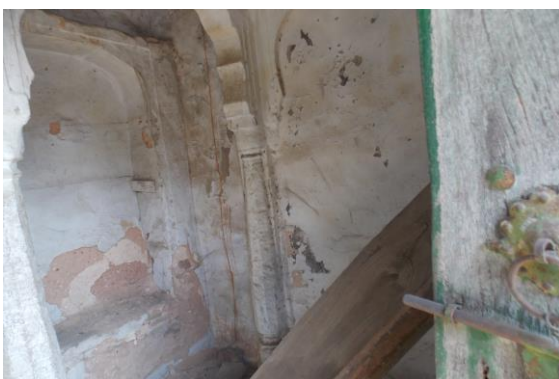
Photo 325

Peeling of Plaster on Wall No. 2 & Minarates No.3 of Part A+B of Temple Shri Anand Bihari Ji of Terrace

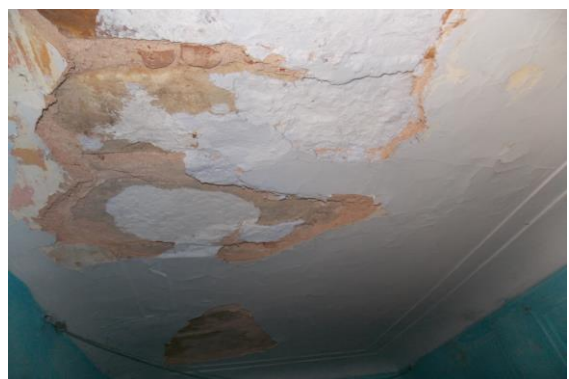
Photo 326

Peeling of Plaster on Roof & Minarates No.4 of Part A+B of Temple Shri Anand Bihari Ji of Terrace

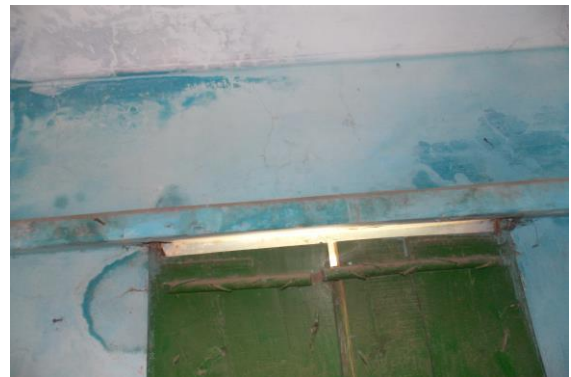
Photo 330

Dampness/Seepage on Wall No. 2 of Minarates No.4 of Terrace

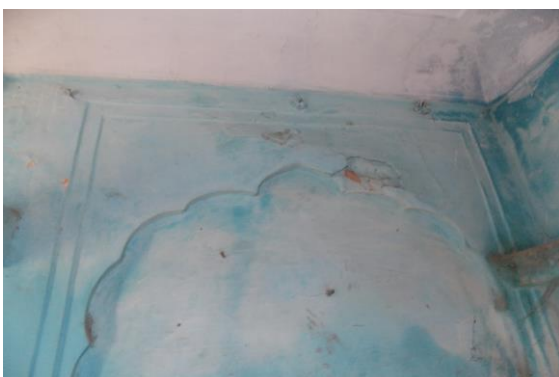
Photo 331

Peeling of Plaster on Wall No. 4 of Part A+B of Temple Shri Anand Bihari Ji of Terrace

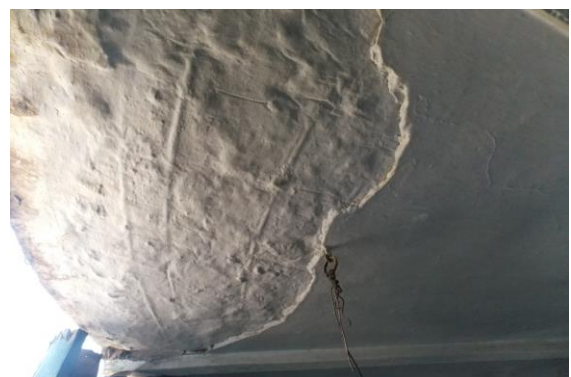
Photo 332

Peeling of Plaster on Outside Sun Shade of Tomb Area No.4 of Terrace

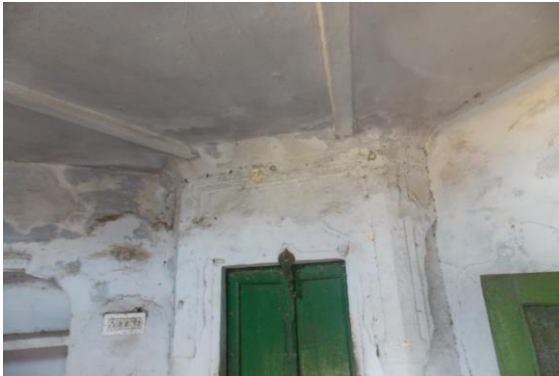
Photo 333

Dampness/Seepage on All Walls & Outsides of Tomb Area No.4 of Terrace

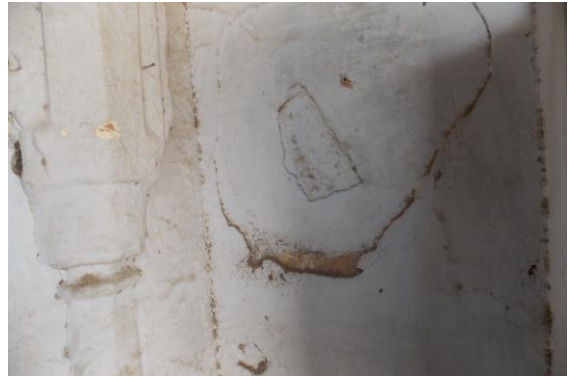
Photo 334

Peeling of Plaster on Outerwall No.2 of Tomb area No.4 of Terrace

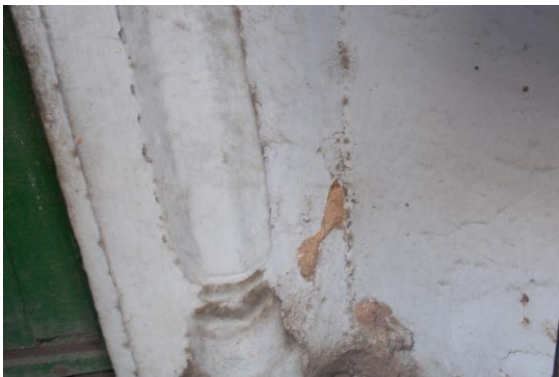
Photo 335

Peeling of Plaster on Outerwall No.4 of Tomb Area No.4 of Terrace

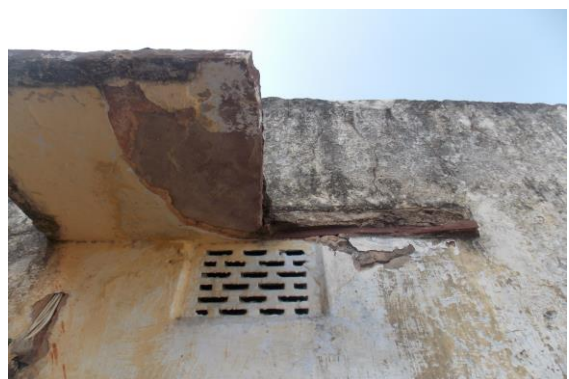
Photo 338

Damaged Portion on External Wall of Room No. 1 of Part A+B of Temple Shri Anand Bihari Ji, Terrace

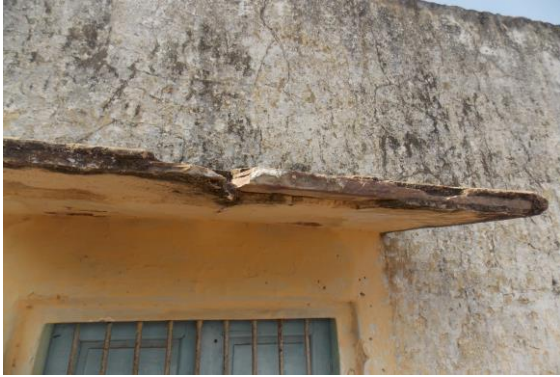
Photo 339

Damaged Portion on Sun Shade Window of Room No. 1 of Part A+B of Temple Shri Anand Bihari Ji, Terrace

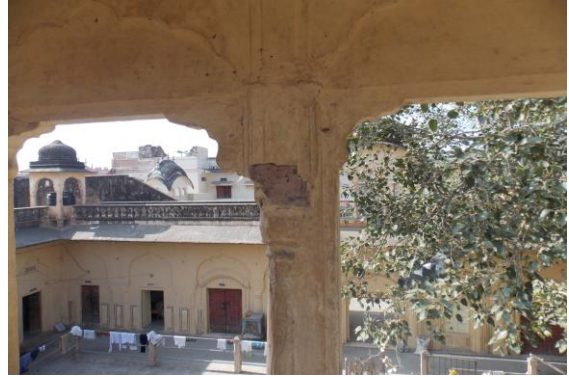
Photo 340

Peeling of Plaster on Wall No. 4 of Minarates No.6 of Part A+B of Temple Shri Anand Bihari Ji, Terrace

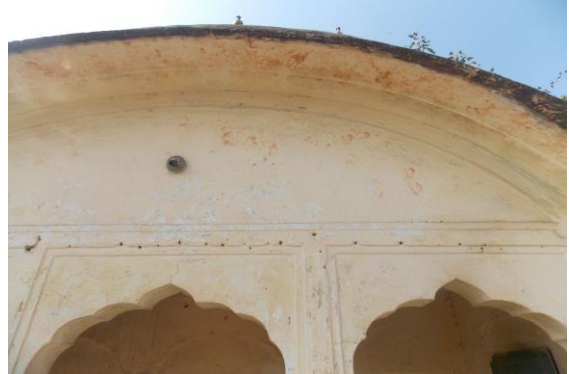
Photo 341

Peeling of Plaster on Roof of Minarates No.6 of Part A+B of Temple Shri Anand Bihari Ji, Terrace

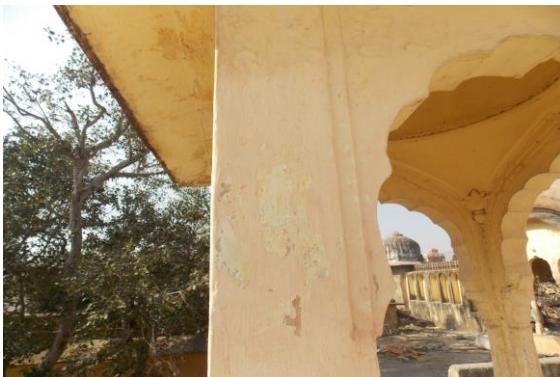
Photo 342

Peeling of Plaster on External Wall of Minarates No.6 of Part A+B of Temple Shri Anand Bihari Ji, Terrace

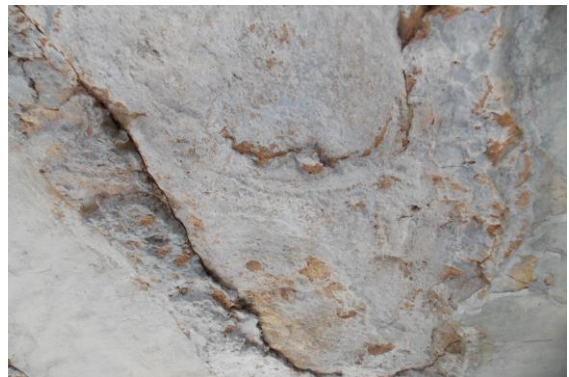
Photo 343

Peeling of Plaster on External Wall of Tomb Area no.6 of Part A+B of Temple Shri Anand Bihari Ji, Terrace

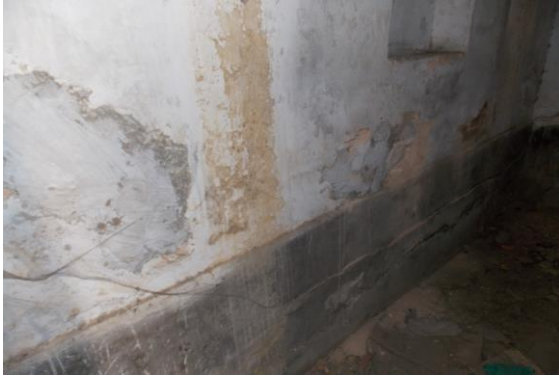
Photo 344

Peeling of Plaster on Roof of Room No. 2 of Part A+B of Temple Shri Anand Bihari Ji, Terrace

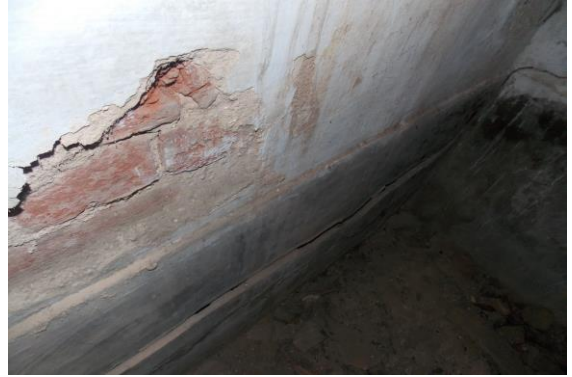
Photo 345

Peeling of Plaster on Wall No. 4 of Room No. 2 of Part A+B of Temple Shri Anand Bihari Ji, Terrace

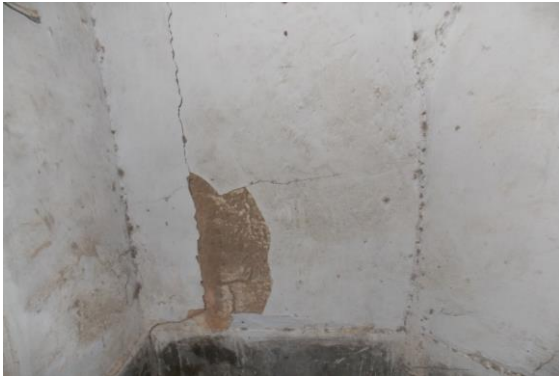
Photo 346

Damaged Portion on Wall No. 4 of Room No. 2 of Part A+B of Temple Shri Anand Bihari Ji, Terrace

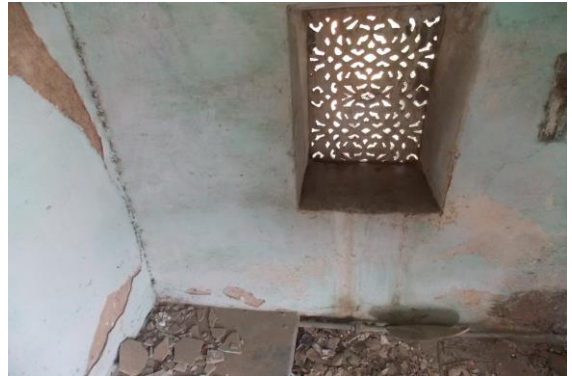
Photo 347

Peeling of Plaster on Wall No. 2 of Room No. 2 of Part A+B of Temple Shri Anand Bihari Ji, Terrace

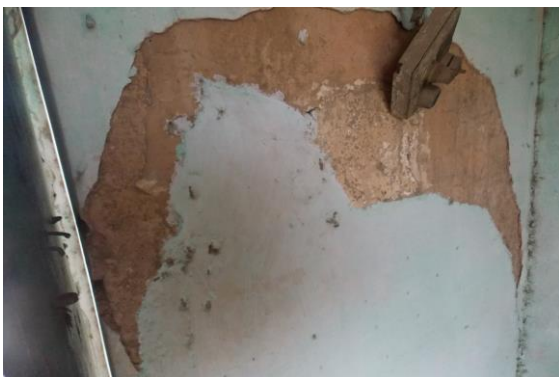
Photo 348

Peeling of Plaster on Wall No. 1 of Room No. 2 of Part A+B of Temple Shri Anand Bihari Ji, Terrace

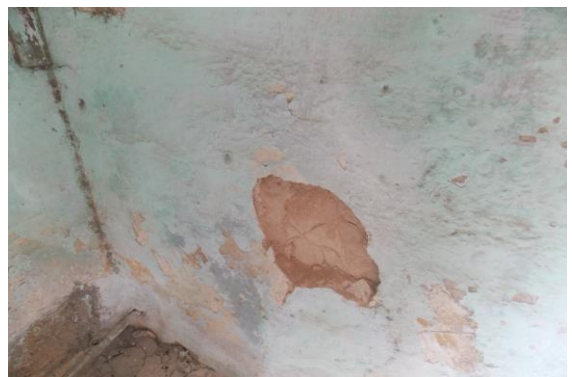
Photo 349

Peeling of Plaster on Wall No. 3 of Room No. 2 of Part A+B of Temple Shri Anand Bihari Ji, Terrace

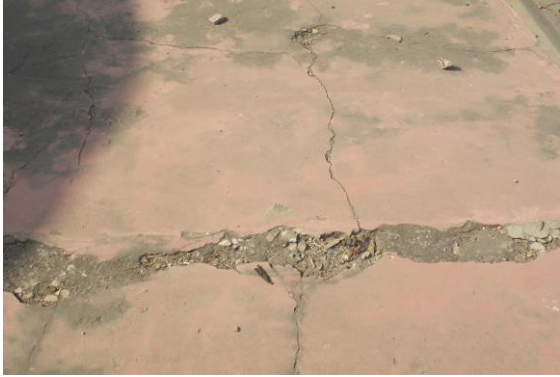
Photo 350

Peeling of Plaster on Wall No. 4 of Room No. 2 of Part A+B of Temple Shri Anand Bihari Ji, Terrace

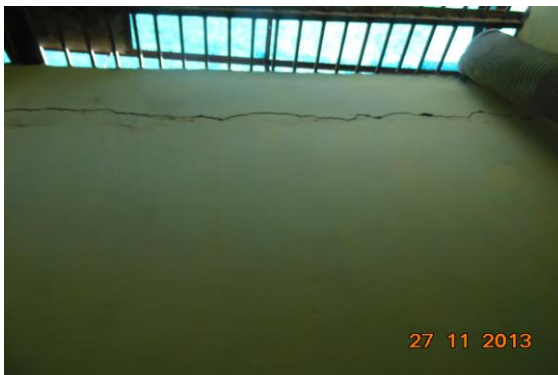
Photo 15
Horizontal Crack on Wall No. 1, 3 & 4 of Passage, First Floor
Approx. Width = 4mm, Approx. Length = 4.5m.
Distance from Wall No. 3 = 0m, Height from Floor = 3.2m.

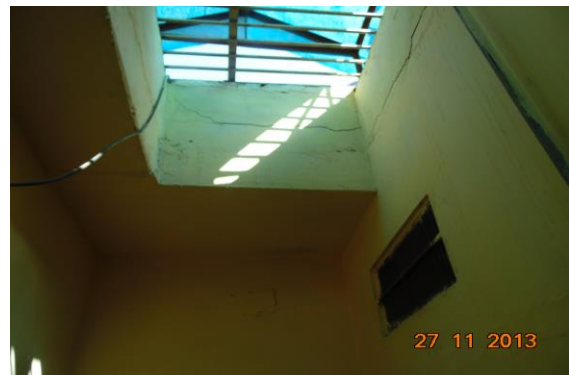
Photo 16
Horizontal Crack on Wall No. 1, 3 & 4 of Passage, First Floor
Approx. Width = 4mm, Approx. Length = 4.5m.
Distance from Wall No. 3 = 0m, Height from Floor = 3.2m.

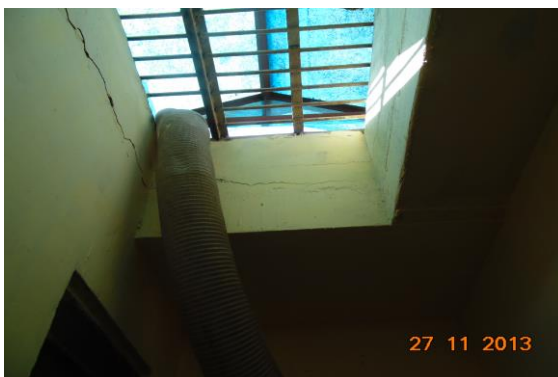
Photo 17
Horizontal Crack on Wall No. 1, 3 & 4 of Passage, First Floor
Approx. Width = 4mm, Approx. Length = 4.5m.
Distance from Wall No. 3 = 0m, Height from Floor = 3.2m.

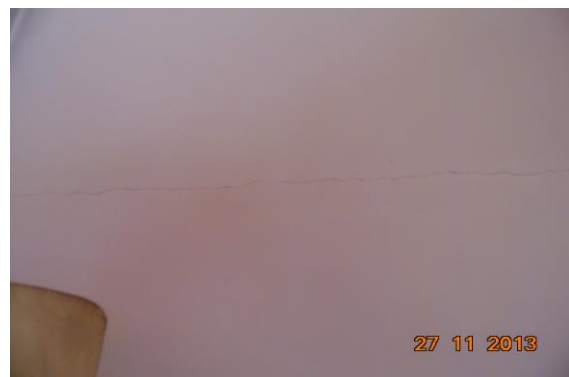
Photo 18
Horizontal Crack on Roof of Office , First Floor
Approx. Width = 0.35mm, Approx. Length = 2.5m.
Distance from Wall No. 2 = 1.8m, Height from Floor = 2.8m.

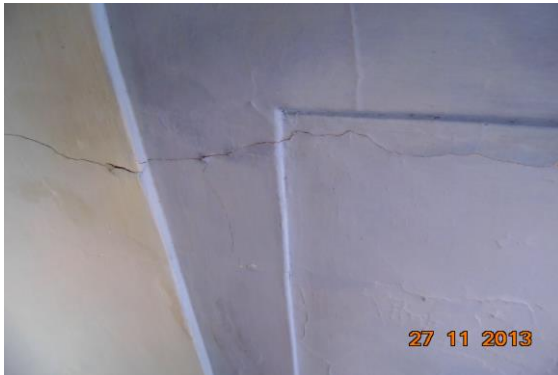
Photo 19
Inclined Crack on Roof of Bsnl Office , First Floor
Approx. Width = 1mm, Approx. Length = 2.2m.
Distance from Wall No. 1 = 0.45m, Height from Floor = 2.1m.

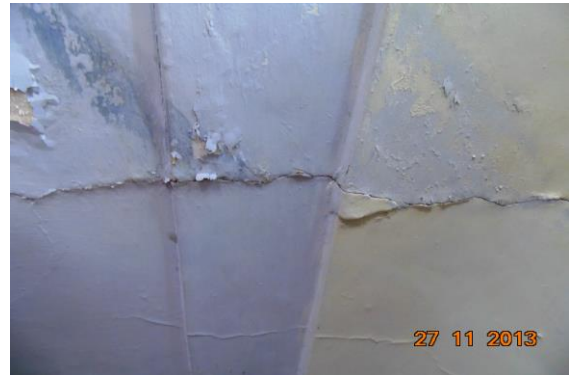
Photo 20
Inclined Crack on Roof of Bsnl Office , First Floor
Approx. Width = 1mm, Approx. Length = 2.5m.
Distance from Wall No. 1 = 2.6m, Height from Floor = 2.1m.

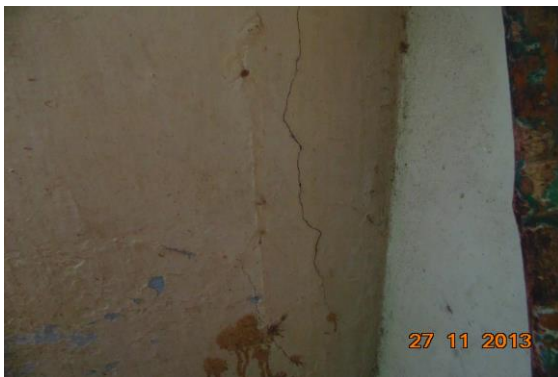
Photo 21
Inclined Crack on Wall No. 3 of Bsnl Office, First Floor
Approx. Width = 0.5mm, Approx. Length = 1m.
Distance from Wall No. 1 = 0m, Height from Floor = 0.4m.

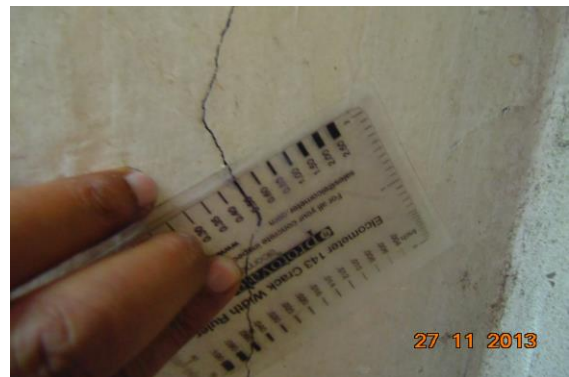
Photo 21A
Inclined Crack on Wall No. 3 of Bsnl Office, First Floor
Approx. Width = 0.5mm, Approx. Length = 1m.
Distance from Wall No. 1 = 0m, Height from Floor = 0.4m.

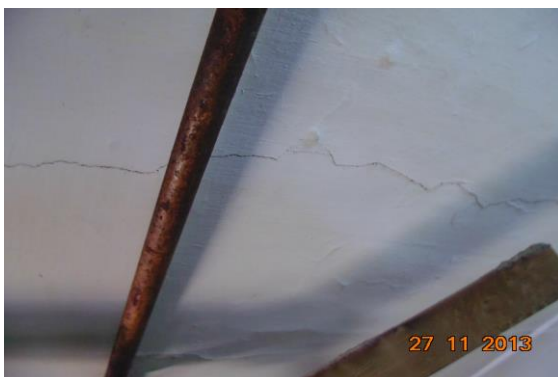
Photo 22
Inclined Crack on Roof of Bsnl Office 2 , First Floor
Approx. Width = 0.8mm, Approx. Length = 3m.
Distance from Wall No.4 = 0m, Height from Floor = 2.25m.

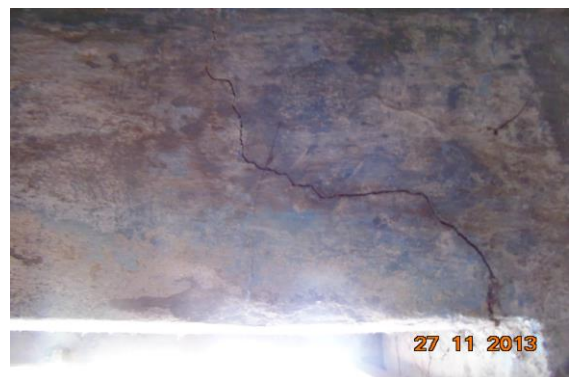
Photo 23
Inclined Crack on Wall No. 4 of Bathroom , First Floor
Approx. Width = 2.5mm, Approx. Length = 0.5m.
Distance from Wall No. 2 = 1.1m, Height from Floor = 1.6m.

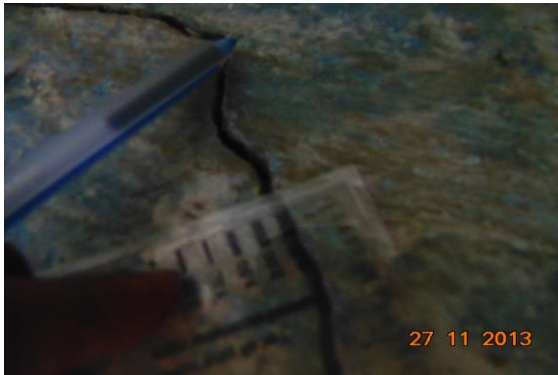
Photo 24

Inclined Crack on Wall No. 4 of Bathroom , First Floor
Approx. Width = 2.5mm, Approx. Length = 0.5m.
Distance from Wall No. 2 = 1.1m, Height from Floor = 1.6m.

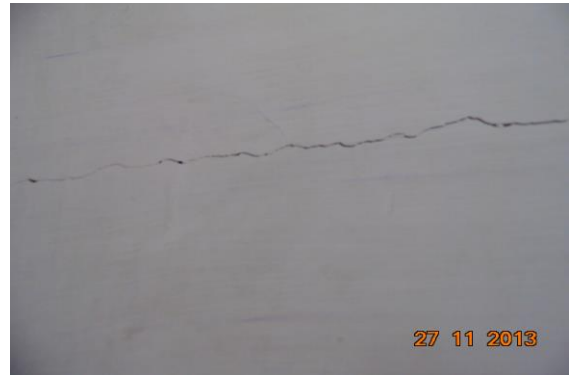
Photo 25

Horizontal Crack on Wall No. 1 of Babu Lal Shop, First Floor
Approx. Width = 0.4mm, Approx. Length = 0.4m.
Distance from Wall No.3 = 0m, Height from Floor = 1.5m.

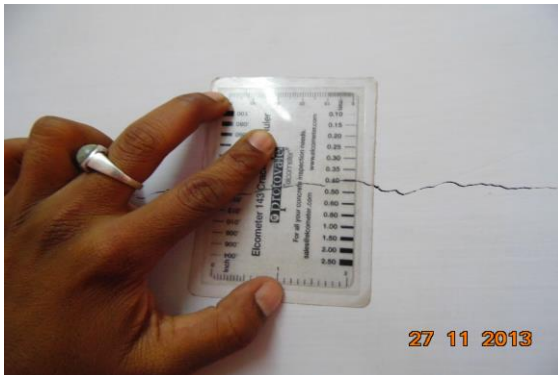
Photo 25A

Horizontal Crack on Wall No. 1 of Babu Lal Shop, First Floor
Approx. Width = 0.4mm, Approx. Length = 0.4m.
Distance from Wall No.3 = 0m, Height from Floor = 1.5m.

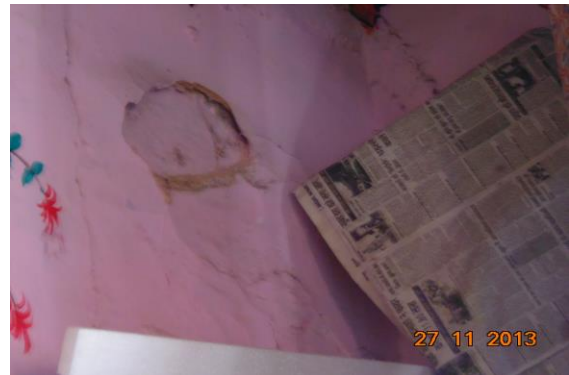
Photo 26

Peeling of Plaster on Wall No. 10 of Laxmi Naryan Mandir of First Floor

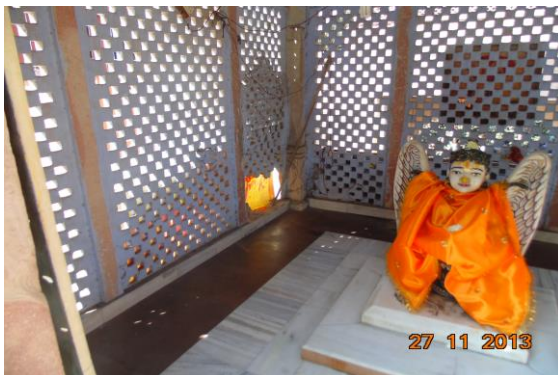
Photo 27

Peeling of Plaster on Wall No. 1 of Garud Mandir of Garud Mandir, First Floor

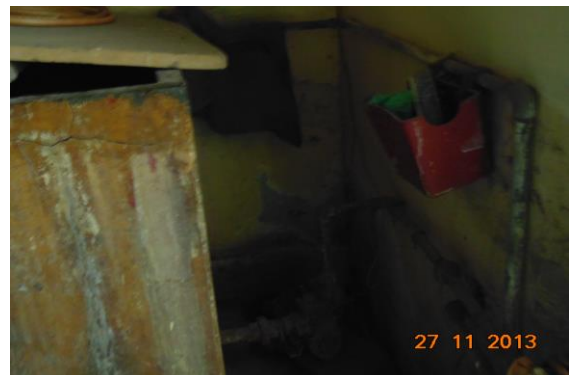
Photo 28

Dampness/Seepage on Wall No. 2 & 4 of Store of First Floor

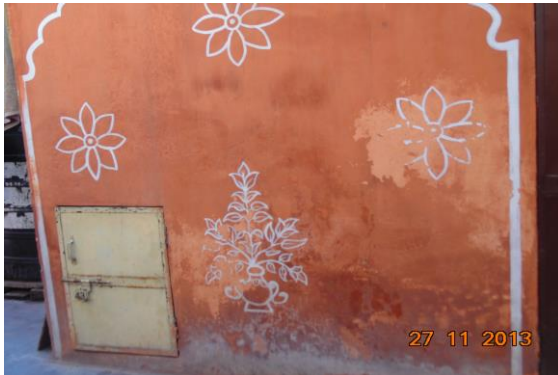
Photo 29

Dampness/Seepage on Outer Wall of Stair 8 of First Floor

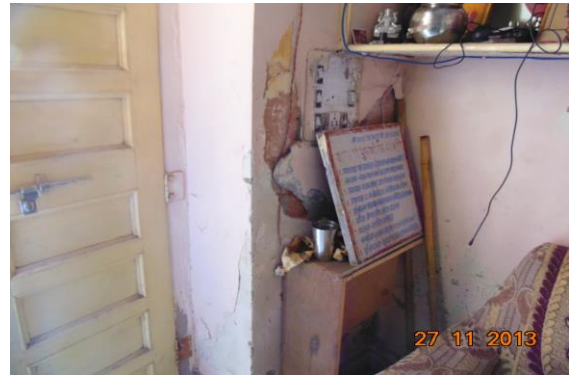
Photo 30

Peeling of Plaster on Wall No. 3 of Office of First Floor

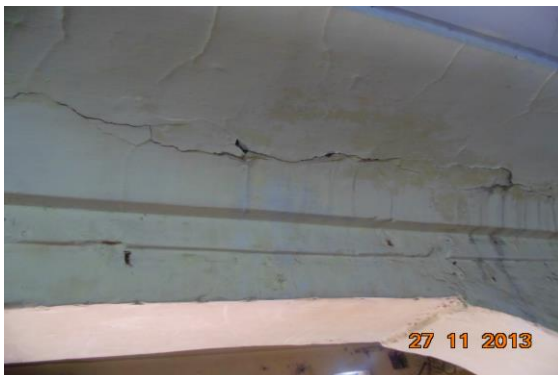
Photo 31

Peeling of Plaster on Wall No.1 & Roof of Bsnl Office of First Floor

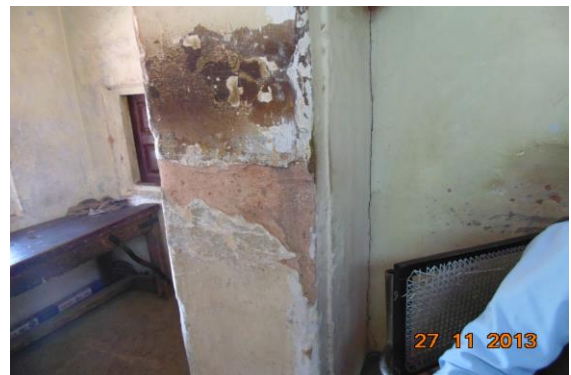
Photo 32

Peeling of Plaster on Wall No. 1 of Bsnl Office of First Floor

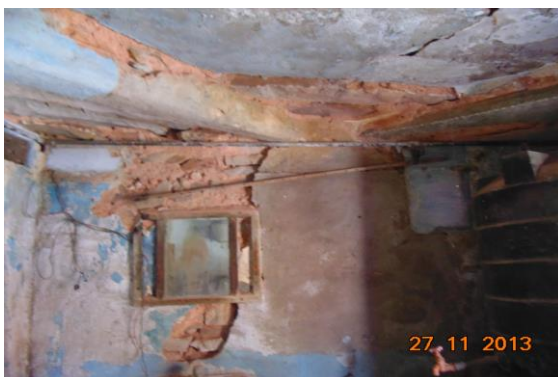
Photo 33

Peeling of Plaster on Wall No. 1 & Roof of Bathroom of First Floor

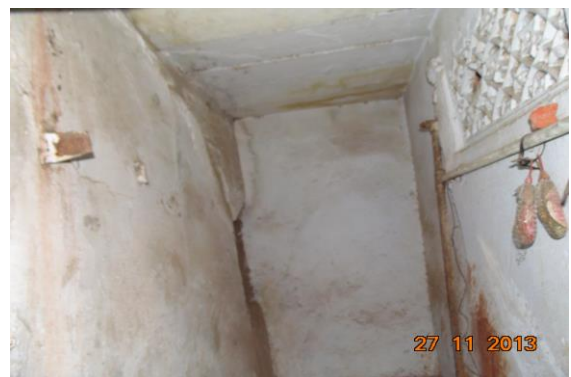
Photo 34

Peeling of Plaster on Wall No. 1, 2 & 4 of Toilet No. 1 of First Floor

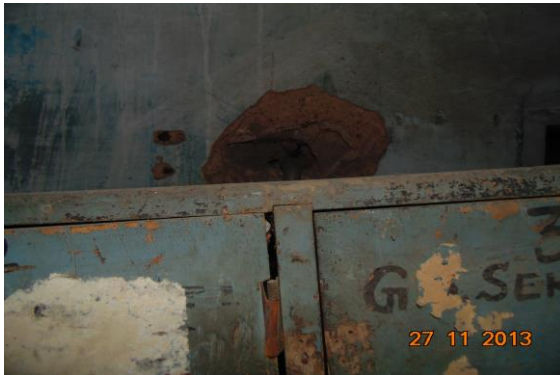
Photo 35

Peeling of Plaster on Wall No. 4 of Laxmi Naryan Mandir of First Floor

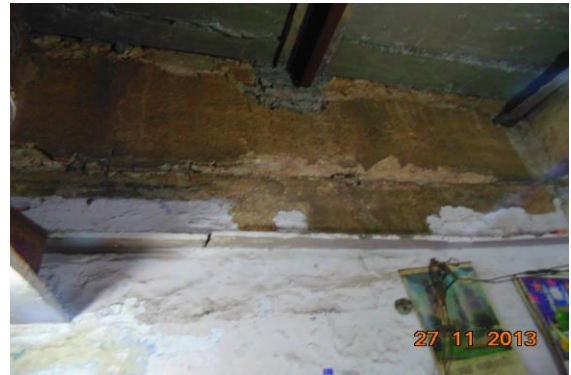
Photo 36

Peeling of Plaster on Wall No. 4 of First Floor

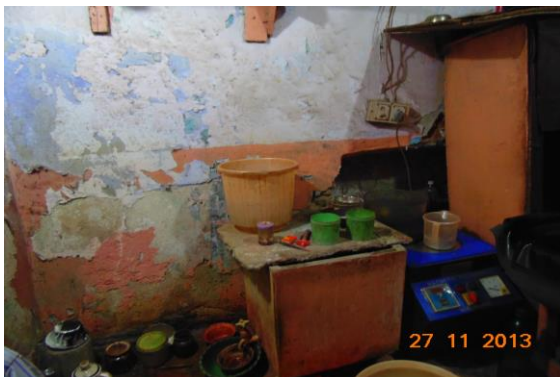
Photo 37

Peeling of Plaster on Wall No. 4 of First Floor

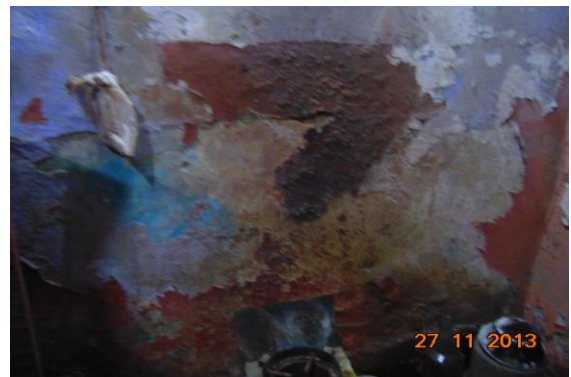
Photo 38

Peeling of Plaster on Wall No. 1 of First Floor

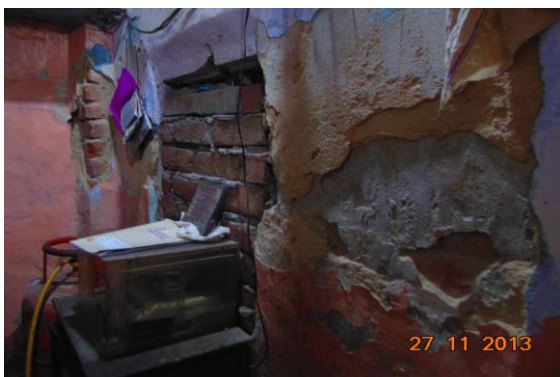
Photo 39

Peeling of Plaster on Wall No. 3 of First Floor

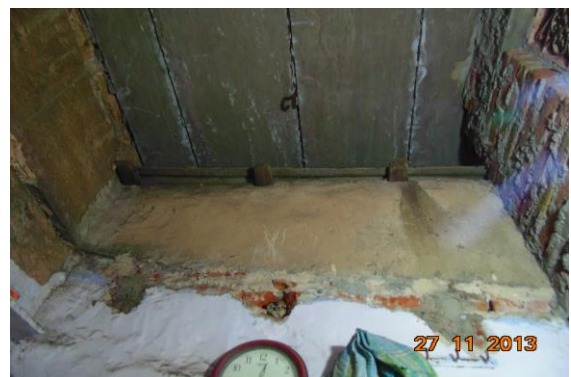
Photo 40

Peeling of Plaster on Wall No. 2 of First Floor

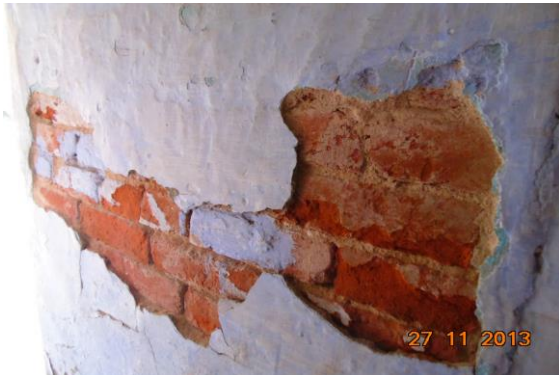
Photo 41
Peeling of Plaster on Outer Wall of First Floor

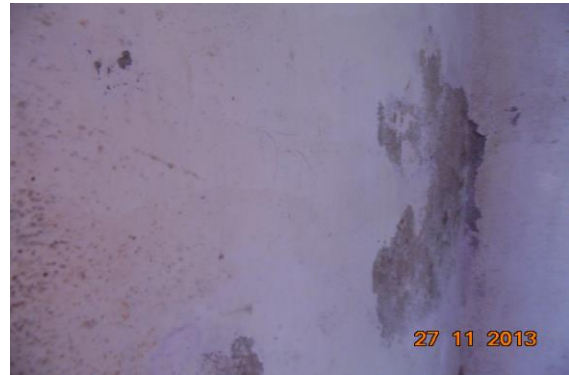
Photo 42
Dampness/Seepage on Outer Wall of First Floor

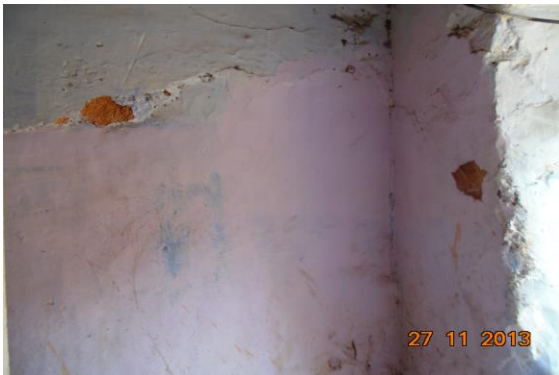
Photo 43
Peeling of Plaster on Wall No. 2 & 3 of Passage Area of First Floor

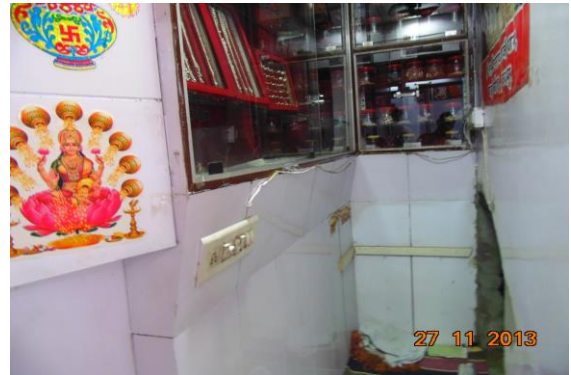
Photo 59
Shop No. 3 Road Side of First Floor Locked
