Pre Building Condition Survey Report

Name and Address of Structure :	Badi Chopar Station Area
---------------------------------	--------------------------

Name of the Project	Contract JMRC-UG1B “Design and Construction of Tunnel between Chandpole and Badi Chouper and reverse line by Shield TBM, Underground Metro Stations at Choti Chouper and Badi Chouper by Cut and Cover Methods on East West Corridor of Jaipur Metro Rail Corporation Limited .”	
Owner :

Pre - Condition Building Survey for Construction of Underground Stations from Chandpole to Bari Chouper and reversal line

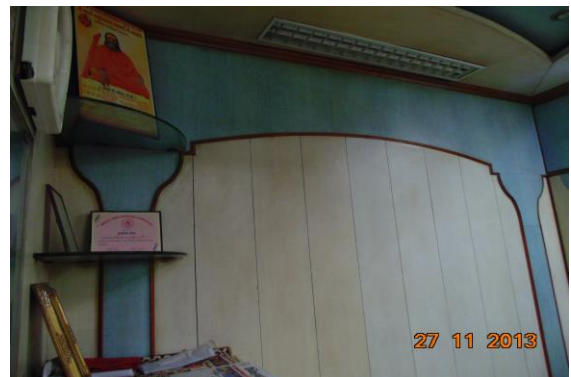
Photo 61
Bala Ji Jeweller of First Floor Locked

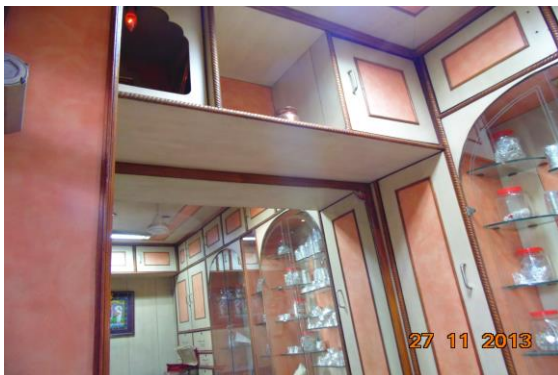
Photo 66
Room No. 1 of First Floor Locked

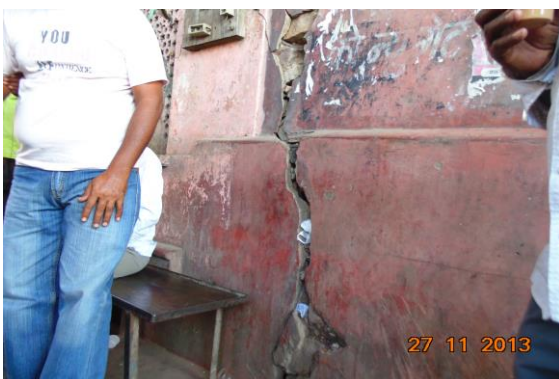
Photo 5
Peeling of Plaster on External Wall No. 4 of Ground Floor

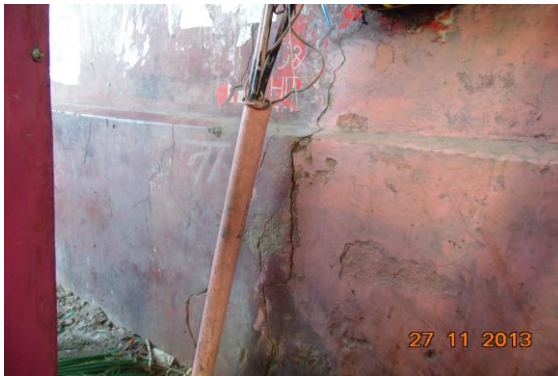
Photo 7
Peeling of Plaster on external Wall No. 2 of Ground Floor

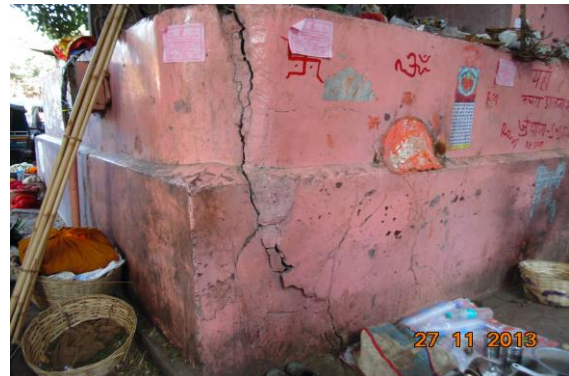
Photo 8
Peeling of Plaster on external Wall No. 3 of Ground Floor

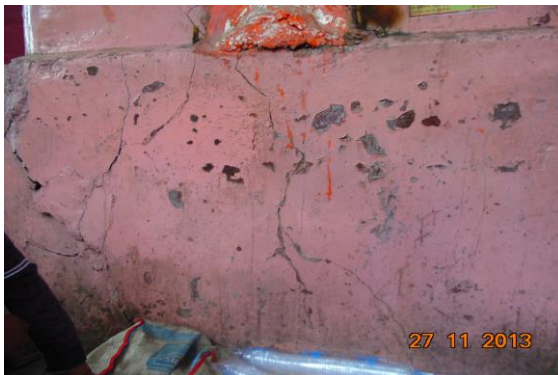
Photo 9
Peeling of Plaster on external Wall No. 3 of Ground Floor

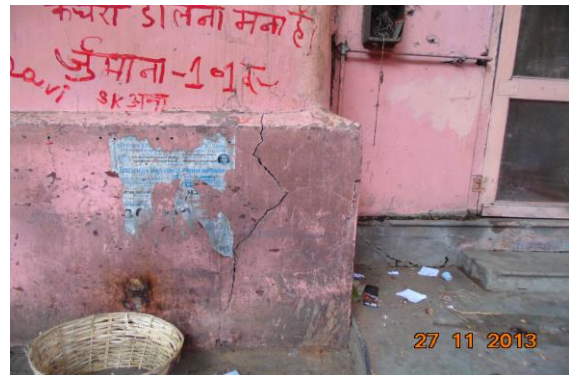
Photo 10
Peeling of Plaster on external Wall No. 3 of Ground Floor

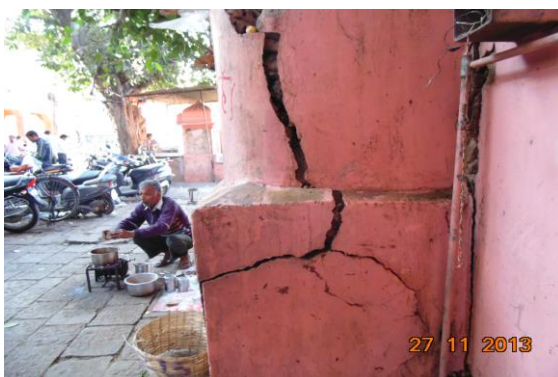
Photo 11
Peeling of Plaster on external Wall No. 1 of Ground Floor

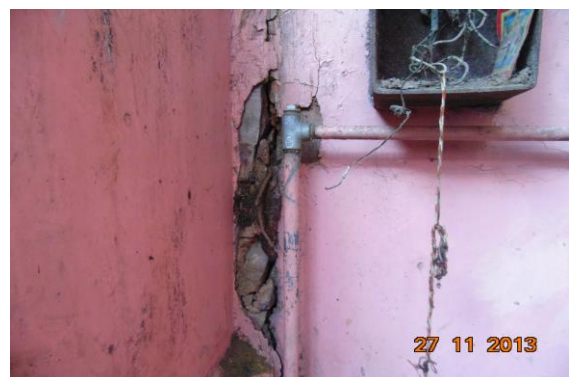
Photo 12
Peeling of Plaster on external Wall No. 1 of Ground Floor

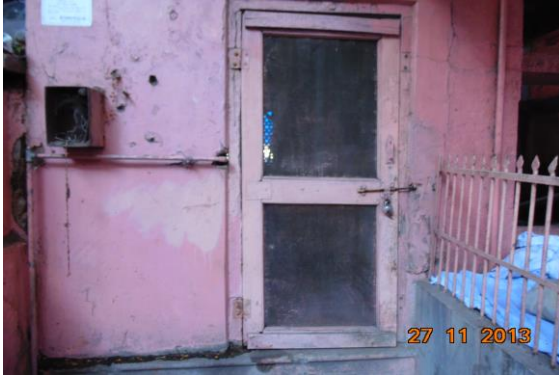
Summary of Areas that Could not be Surveyed			
Serial No.	Location	Description	Photo No.
1	Piyau Ground Floor	Locked	13

Photo 13
Piyau of Ground Floor Locked

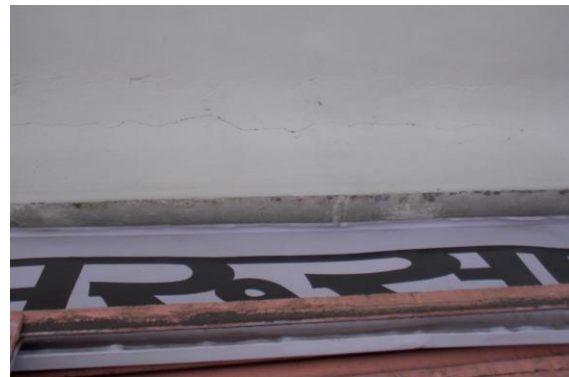
Photo 15
Horizontal Crack on Roof of Varanda of shop, Ground floor Approx.
Width = 3mm, Approx. Length = 2.5m. Distance from Rightside External
Column = 0m, Height from Floor = 3m.

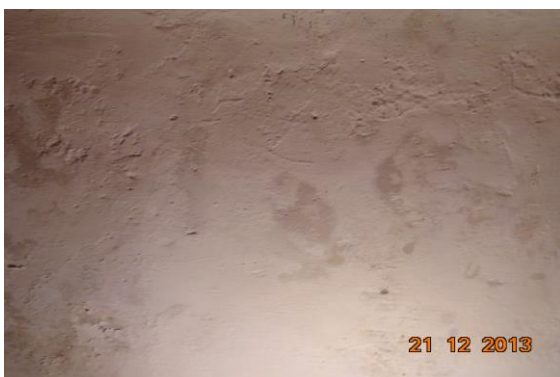
Photo 16
Horizontal Crack on Varandah Roof, Shop No. 195, Ground Floor
Approx. Width = 0.35mm, Approx. Length = 2.5m.
Distance from Right External Col = 0m, Height from Floor = 3m.

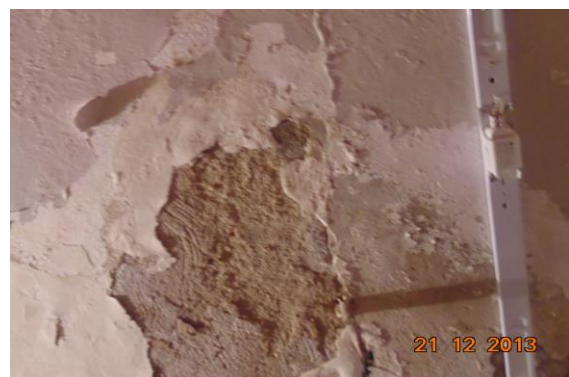
Photo 17
Dampness/Seepage on Roof of Varanda of shop of Ground floor

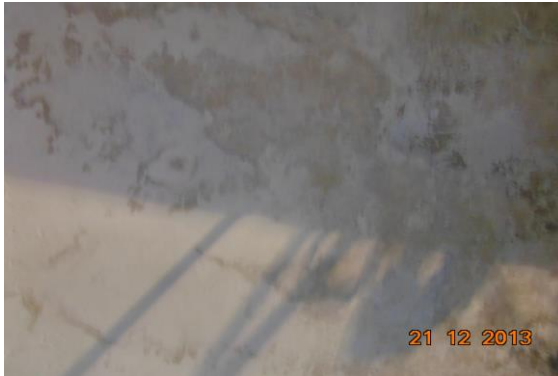
Photo 19

Dampness/Seepage on Roof of Varanda of shop of Ground floor

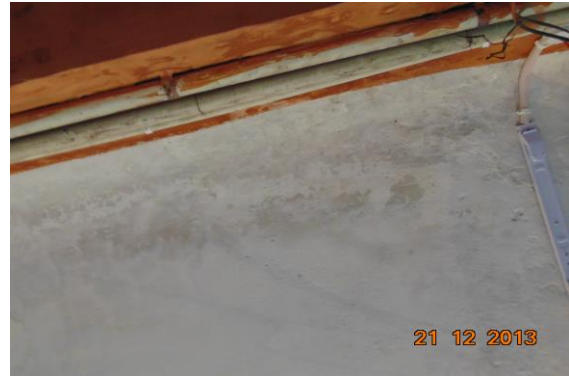
Photo 20

Dampness/Seepage on Roof of Varanda of shop of Ground floor

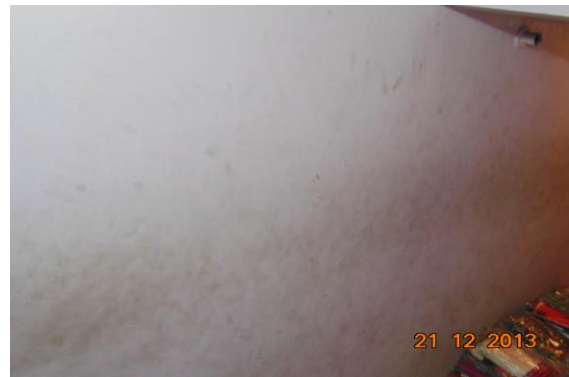
Photo 22

Dampness/Seepage on Wall No. 1 of Shop no.196A of Basement

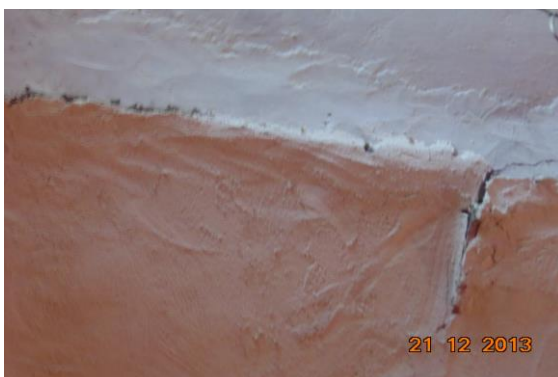
Photo 23

Peeling of Plaster on Roof of Varanda of shop of Ground floor

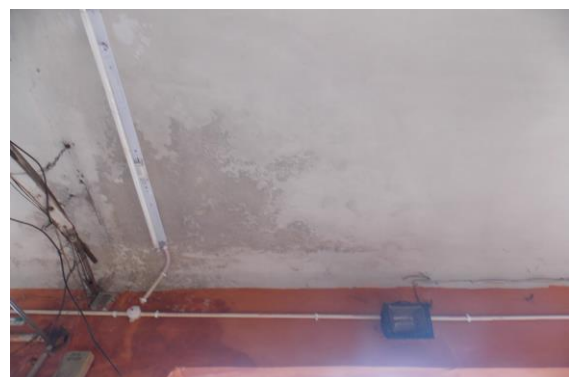
Photo 24

Dampness/Seepage on of Varandah Roof of Shop No. 195, Ground Floor

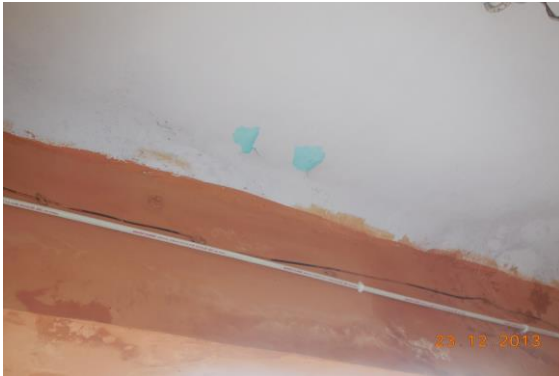
Photo 25

Peeling of Plaster on Roof of Varanda of Shop No.17 of Ground Floor

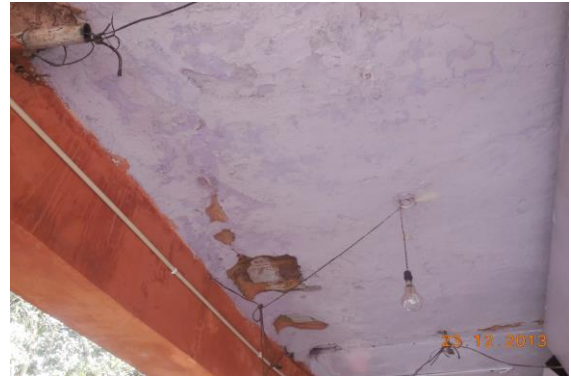
Photo 26

Damaged Portion on Roof of Varanda of Shop No.22 of Ground Floor

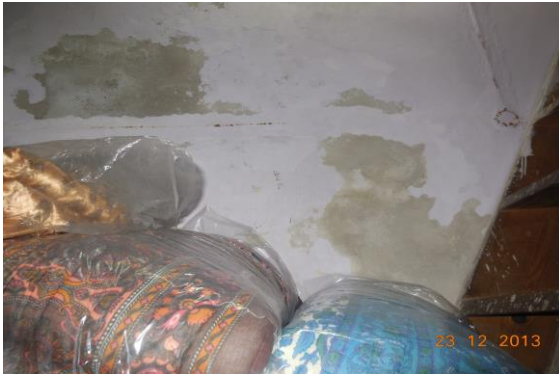
Photo 27

Peeling of Plaster on Wall No. 1 of Part B of Shop no.21 of Ground Floor

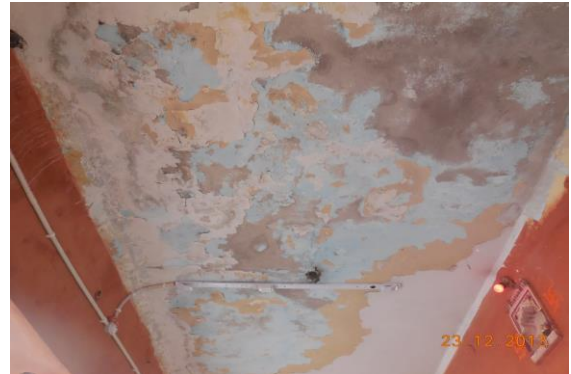
Photo 28

Peeling of Plaster on Roof of Varanda of Shop No.18 of Ground Floor

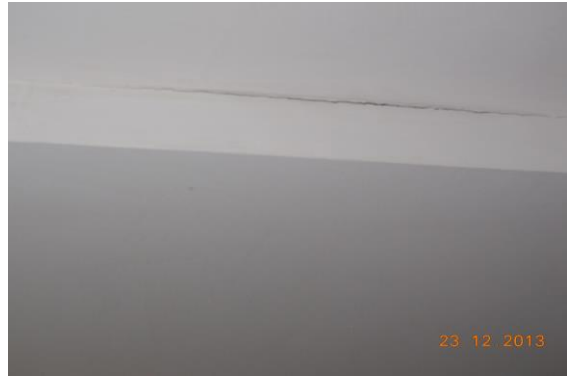
Photo 8
Horizontal Crack on Wall No. 1 of Staircase Third Floor to Fourth Floor
Approx. Width = 0.6mm, Approx. Length = 2m. Distance from Wall No.4
= 0.6m, Height from Floor = 1.5m.

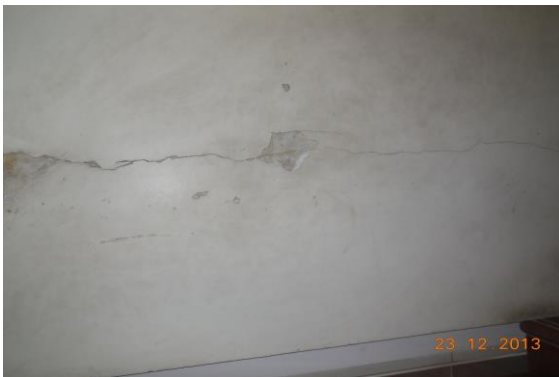
Photo 8A
Horizontal Crack on Wall No. 1 of Staircase Third Floor to Fourth Floor
Approx. Width = 0.6mm, Approx. Length = 2m. Distance from Wall No.4
= 0.6m, Height from Floor = 1.5m.

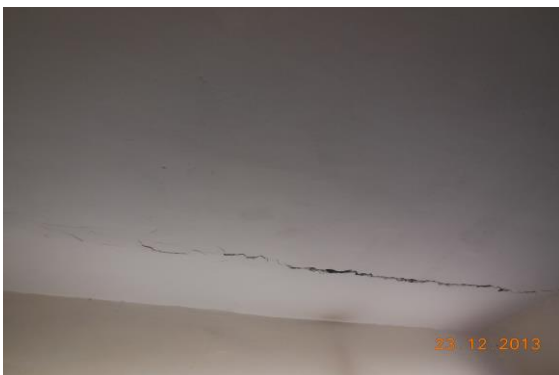
Photo 10
Horizontal Crack on Roof of Varanda of Shop No.16, Ground Floor,
Approx. Width = 1mm, Approx. Length = 2.5m.
Distance from Rightside External Column = 0m, Height from Floor = 3m.

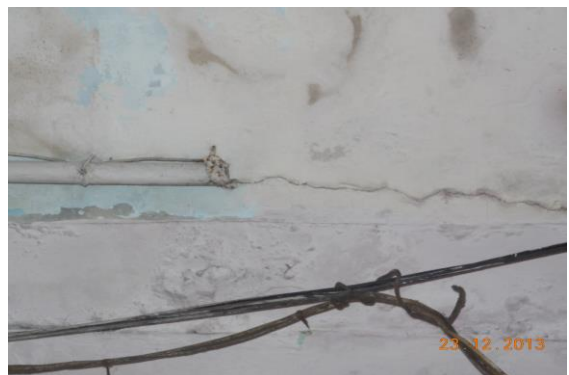
Photo 11

Horizontal Crack on Roof of Varanda of Shop No.15, Ground Floor,
Approx. Width = 2mm, Approx. Length = 2.5m.
Distance from Rightside External Column = 0m, Height from Floor = 3m.

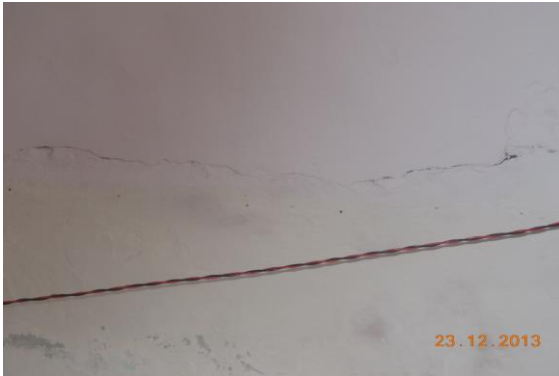
Photo 12

Dampness/Seepage on Wall No. 4 of Hall No. 1 of K.K.Saree Godown
Above Shop No.15 & 16, Third Floor

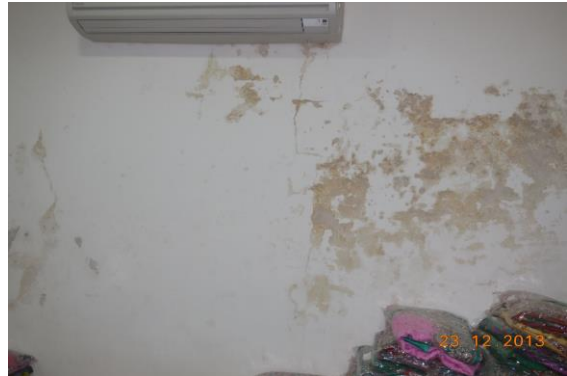
Photo 13

Peeling of Plaster on Roof of Hall No. 1 of K.K.Saree Godown Above
Shop No.15 & 16, Third Floor

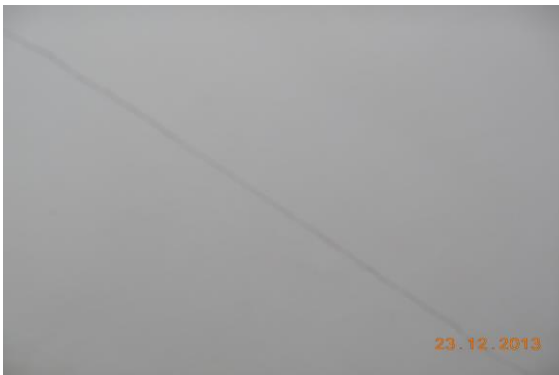
Photo 14

Peeling of Plaster on Roof of Hall No. 2 of K.K.Saree Godown Above
Shop No.15 & 16, Third Floor

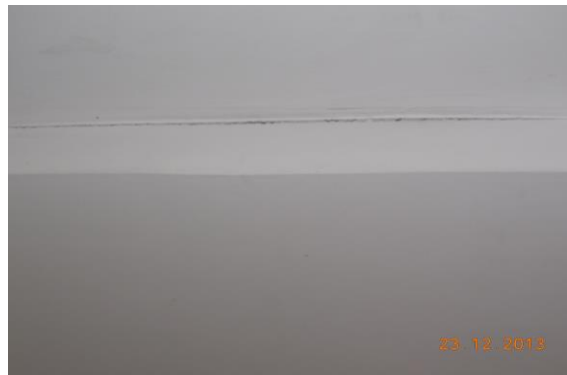
Photo 15

Dampness/Seepage on Wall No. 1 & 4 of Gallery of Third Floor

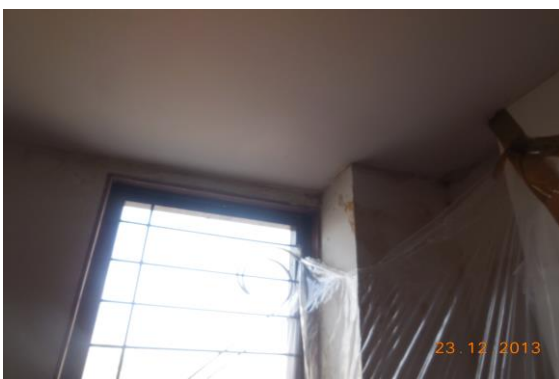
Photo 16

Dampness/Seepage on Wall No. 4 of Hall No. 1 of Godown of Above
Shop No.13 & 14, Third Floor

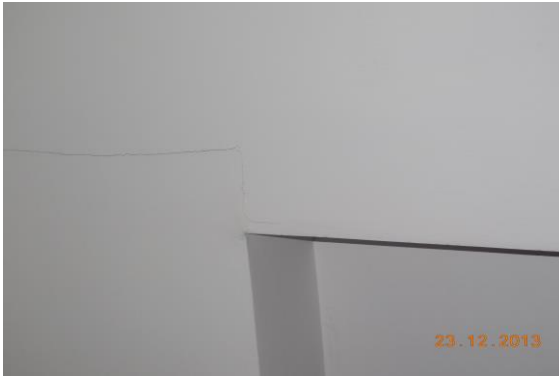
Photo 18

Dampness/Seepage on Wall No. 4 & Floor of Staircase Third Floor to Fourth Floor of Third Floor

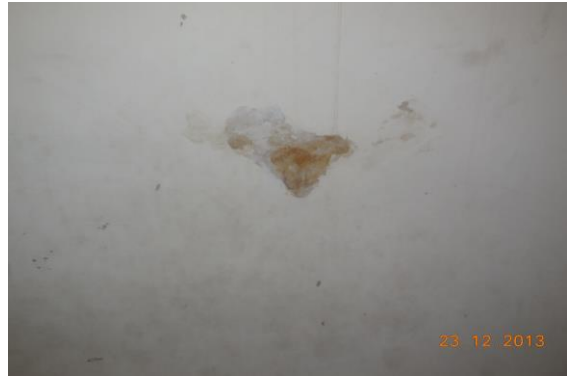
Photo 19

Dampness/Seepage on Wall No. 1 of Staircase Third Floor to Fourth Floor of Third Floor

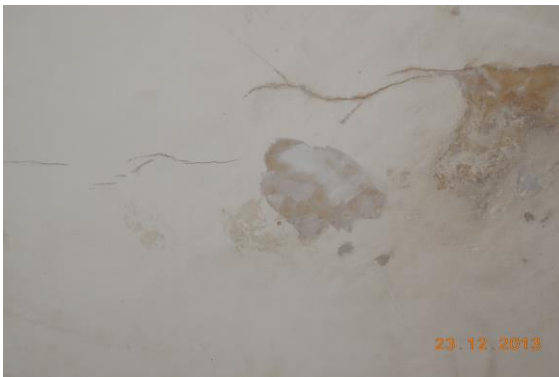
Photo 20

Dampness/Seepage on Wall No. 1, 4 & Roof of Lobby Above Shop No.13 & 14 of Fourth Floor

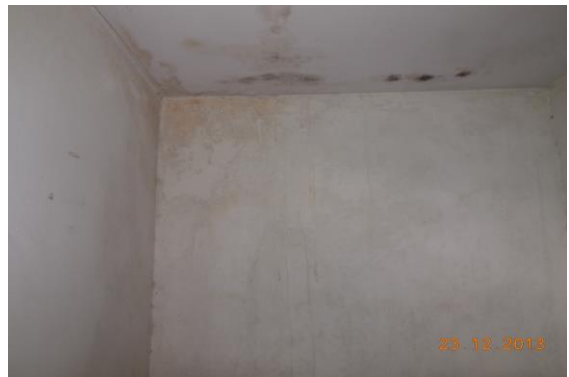
Photo 21

Peeling of Plaster on Wall No. 1 & Roof of Lobby Above Shop No.13 & 14 of Fourth Floor

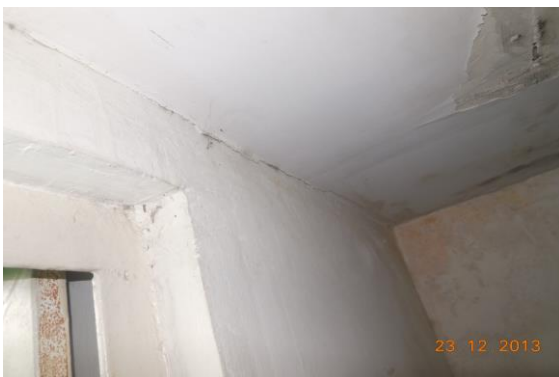
Photo 22

Dampness/Seepage on Wall No. 2 & 4 of D.G.Room Above Shop No.13 & 14 of Fourth Floor

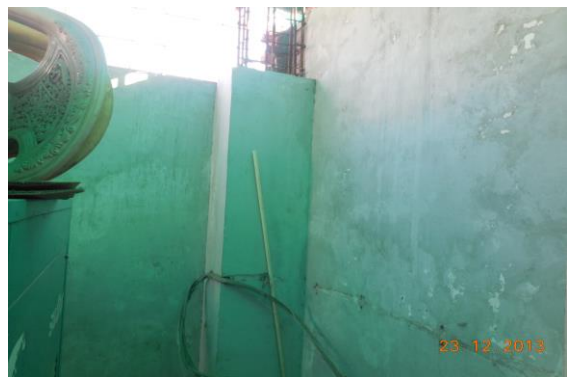
Photo 23

Peeling of Plaster on Wall No. 3 of D.G.Room Above Shop No.13 & 14 of Fourth Floor

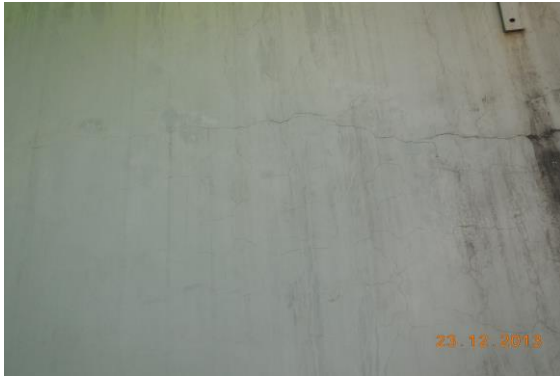
Photo 24

Dampness/Seepage on Wall No. 4 of D.G.Room Above Shop No.13 & 14 of Fourth Floor

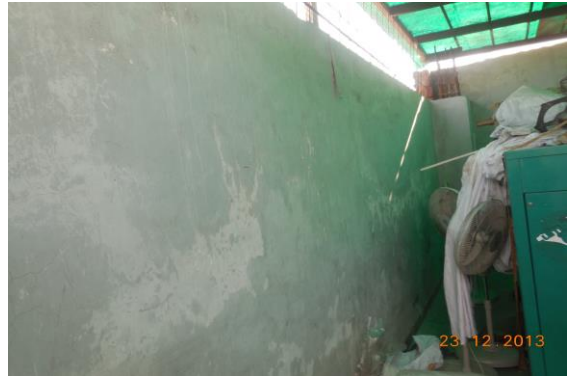
Photo 25

Peeling of Plaster on Wall No. 4 of D.G.Room Above Shop No.13 & 14 of Fourth Floor

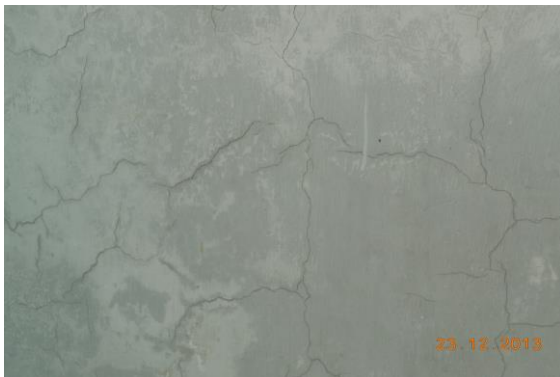
Photo 26

Dampness/Seepage on Wall No. 2 of Room No. 1 of K.K.Saree Godown Above Shop No.15 & 16, Fourth Floor

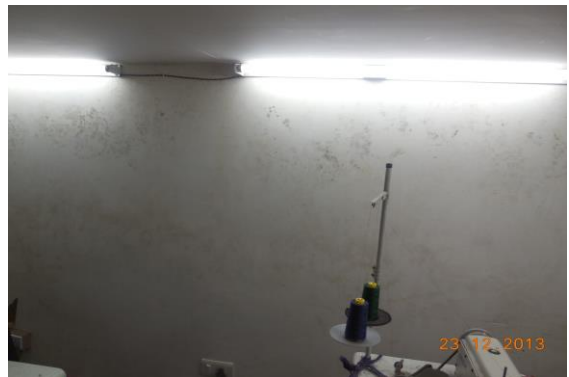
Photo 27

Peeling of Plaster on Roof of Room No. 1 of K.K.Saree Godown Above Shop No.15 & 16, Fourth Floor

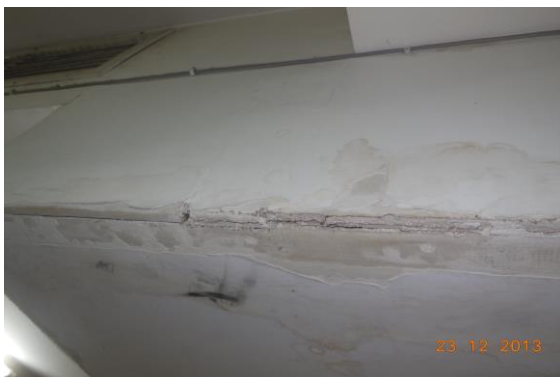
Photo 28

Dampness/Seepage on Wall No. 2 of Room No. 2 of K.K.Saree Godown Above Shop No.15 & 16, Fourth Floor

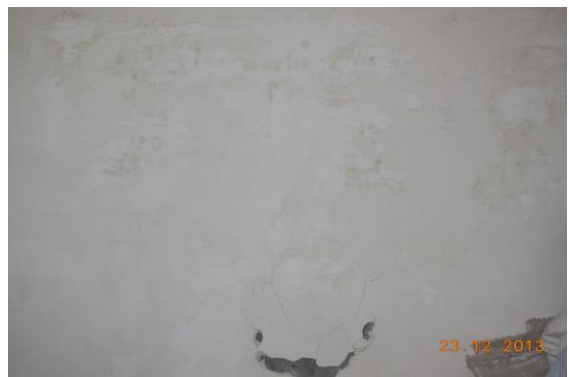
Photo 29

Dampness/Seepage on Roof of Room No. 2 of K.K.Saree Godown
Above Shop No.15 & 16, Fourth Floor

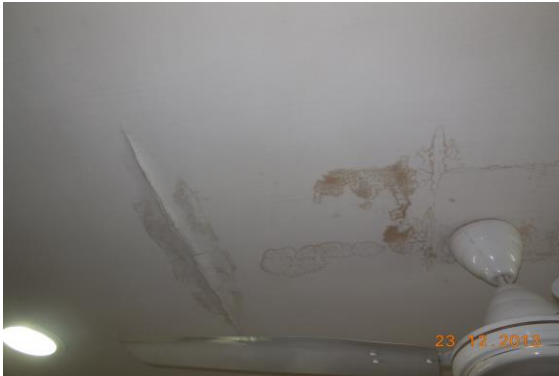
Photo 30

Dampness/Seepage on Wall No. 2, 4 & Roof of Toilet No. 1 of
K.K.Saree Godown Above Shop No.15 & 16, Fourth Floor

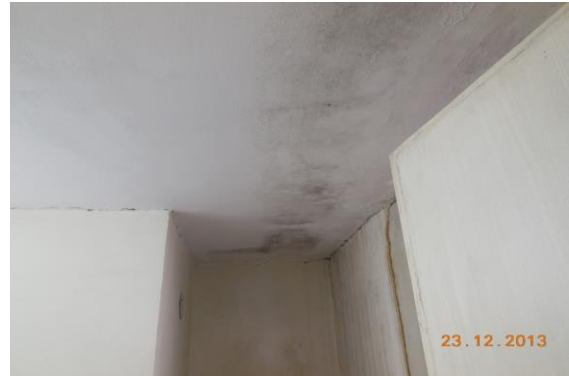
Photo 31

Peeling of Plaster on Roof of Lobby Above Shop No.13 & 14 of Second
Floor

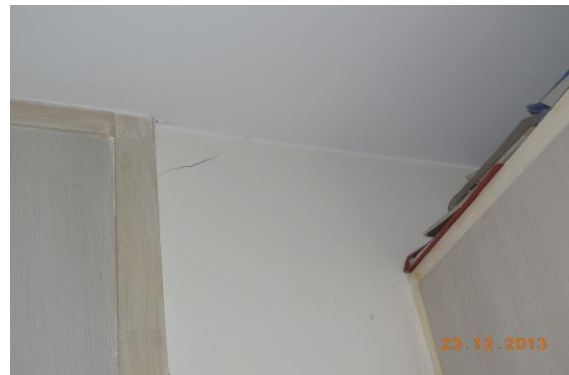
Photo 33

Dampness/Seepage on Wall No. 1, 3 & Roof of Kitchen Above Shop
No.15 & 16 of Second Floor

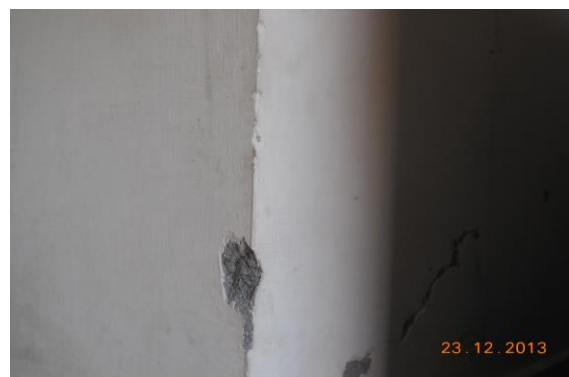
Photo 35

Peeling of Plaster on Roof of Varanda of Shop No.16 of Ground Floor

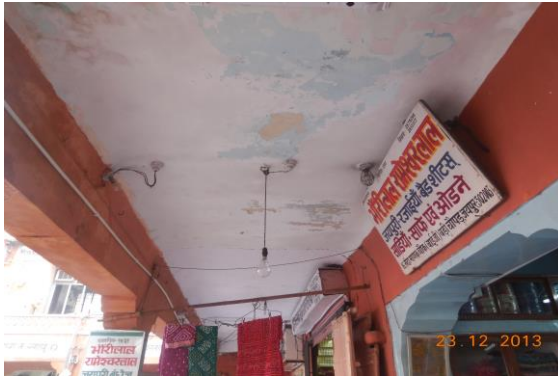
Photo 36

Peeling of Plaster on Beam of Varanda of Shop No.16 of Ground Floor

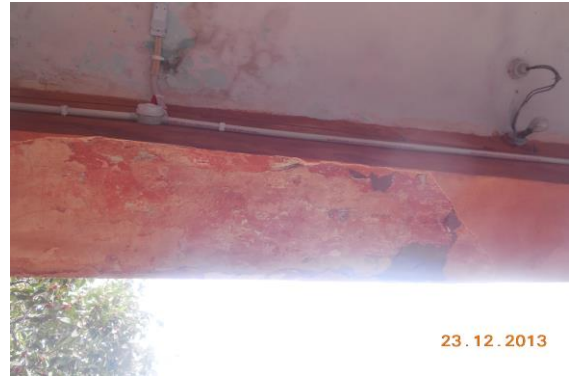
Photo 37

Peeling of Plaster on Roof of Part A of Shop No.16 of Ground Floor

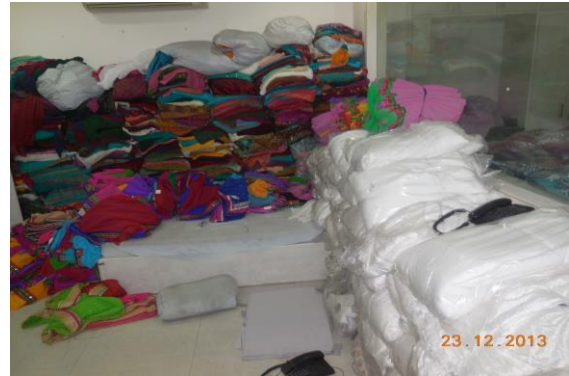
Photo 41

Wall No. 2 & 3 of Hall No. 2 of K.K.Saree Godown Above Shop No.15 & 16, Third Floor Covered With cloths

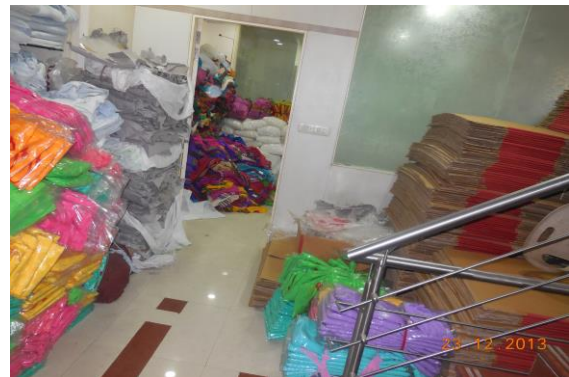
Photo 43

Floor of K.K.Saree Godown Above Shop No.15 & 16 of Third Floor Covered With Tiles

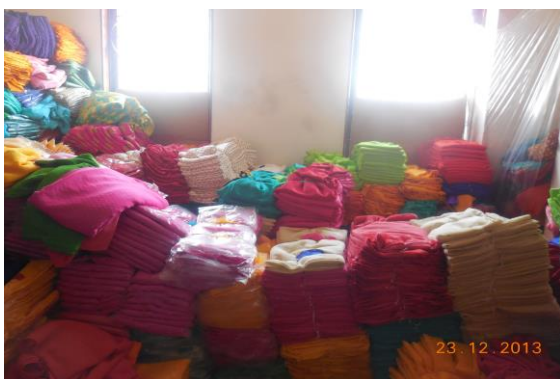
Photo 44

All Walls of Lobby Above Shop No.13 & 14 of Third Floor Covered With Cloths

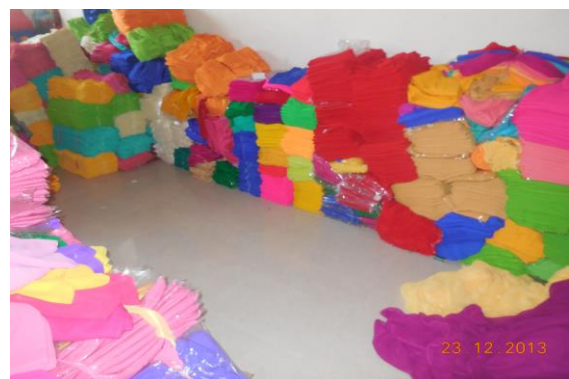
Photo 45

All Walls of Gallery of Third Floor Covered with Cloths

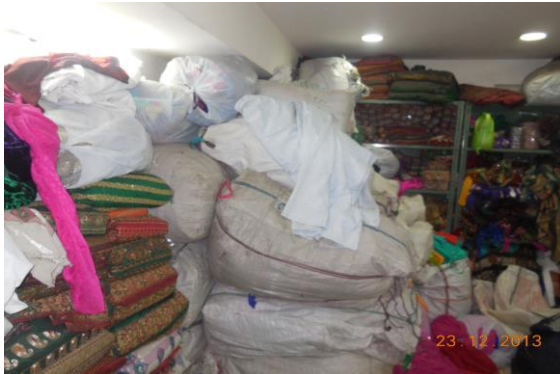
Photo 48

Wall No. 3 of Room No. 1 of K.K.Saree Godown Above Shop No.15 & 16, Fourth Floor Covered

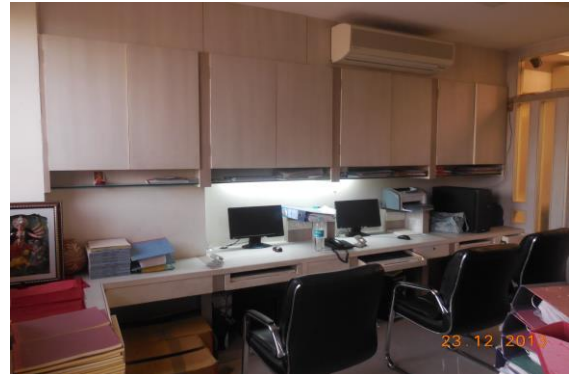
Photo 49

Wall No. 2 & 3 of Room No. 2 of K.K.Saree Godown Above Shop No.15 & 16, Fourth Floor Covered

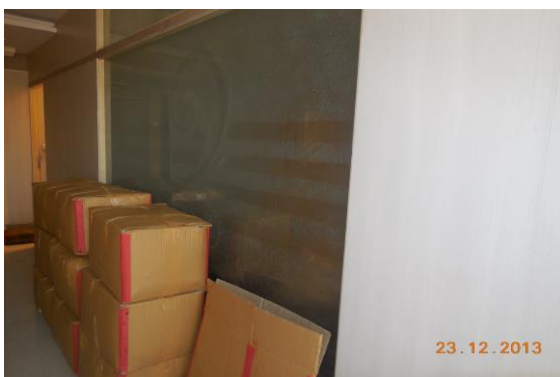
Photo 50

Wall No. 4 of Room No. 2 of Above Shop No.13 & 14, Second Floor Covered With Wooden Work

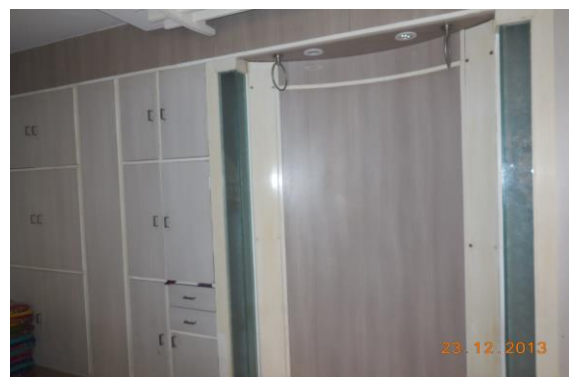
Photo 51

Wall No. 4 of Lobby Above Shop No.13 & 14 of Second Floor Covered

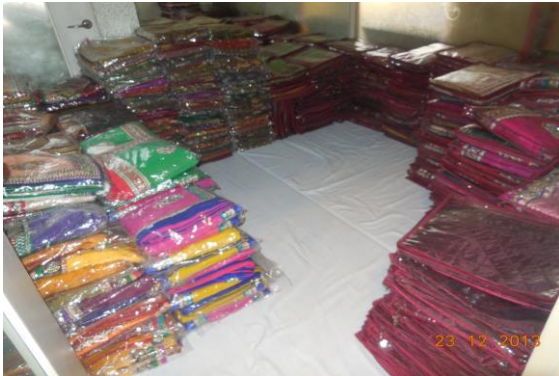
Photo 52

Wall No. 1 of Lobby Above Shop No.13 & 14 of Second Floor Covered

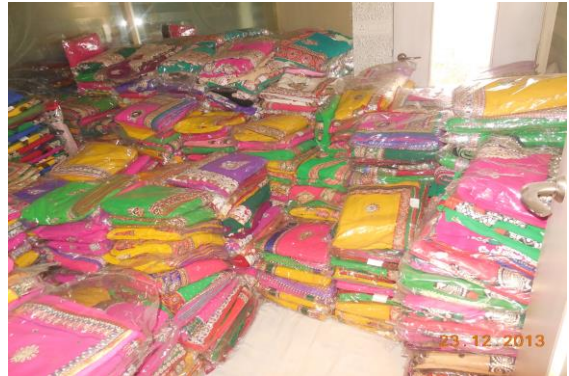
Photo 53

All Walls of Room No. 1 of Above Shop No.15 & 16, Second Floor
Bottom Portion Covered

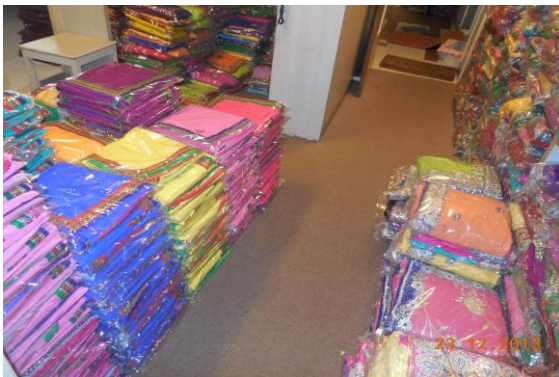
Photo 54

All Walls of Room No. 2 of Above Shop No.15 & 16, Second Floor
Bottom Portion Covered

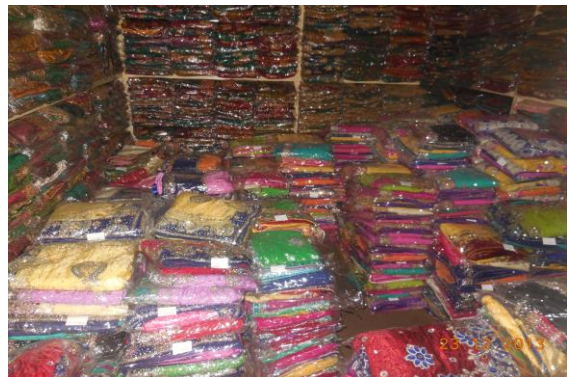
Photo 55

All Walls of Lobby Above Shop No.15 & 16 of Second Floor Bottom
Portion Covered

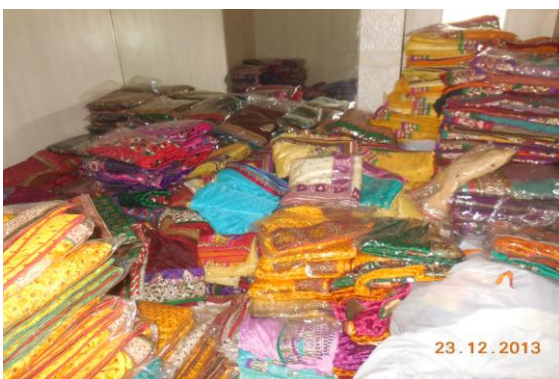
Photo 56

All Walls of Hall No. 1 of Above Shop No.13 & 14, Second Floor
Covered With Cloths

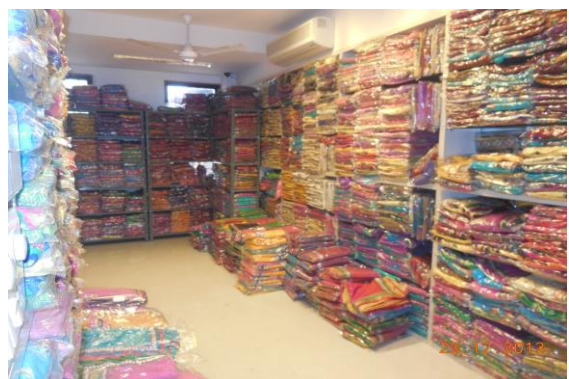
Photo 57

All Walls of Hall No. 2 of Above Shop No.15 & 16, Second Floor
Covered With Cloths

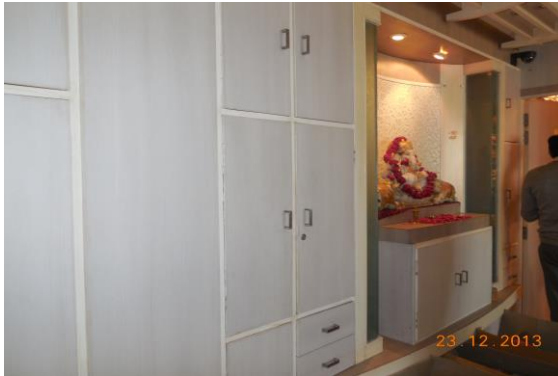
Photo 58

All Walls of Hall No. 1 of Above Shop No.13 & 14, First Floor Covered
With Cloths

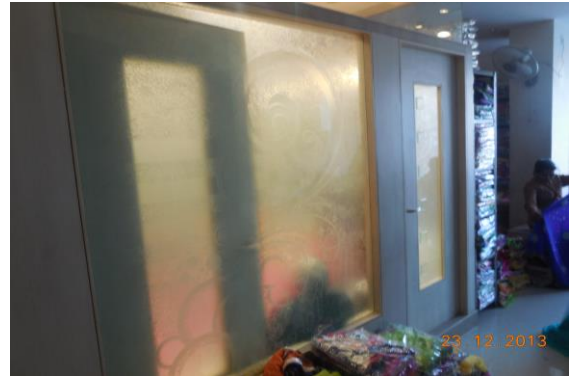
Photo 59

Wall No. 1 of Lobby Above Shop No.13 & 14 of First Floor Covered With Wooden Work

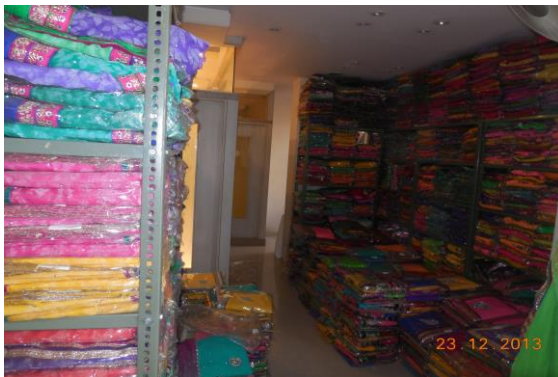
Photo 60

Wall No. 4 of Lobby Above Shop No.13 & 14 of First Floor Covered With Wooden Work

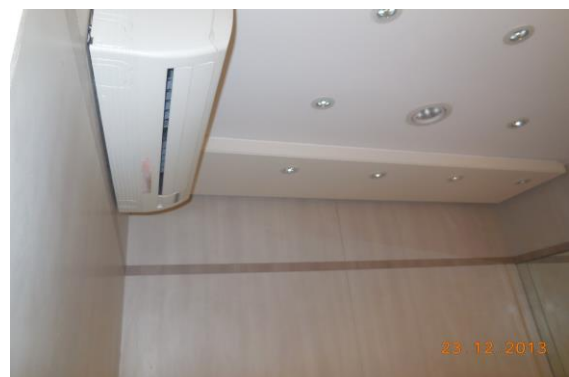
Photo 63

Wall No. 4 of Room No. 3 of Above Shop No.15 & 16, First Floor Covered With Glass Work

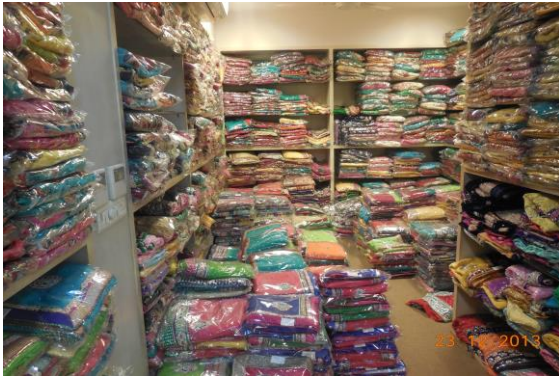
Photo 64

Roof, Wall No. 3 & 1 of Above Shop No.15 & 16 of First Floor Covered With Wooden Work

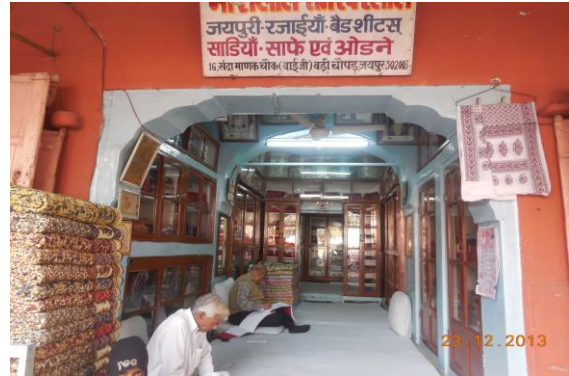
Photo 65

All Walls of Passage of Above Shop No.15 & 16 of First Floor Covered With Cloths

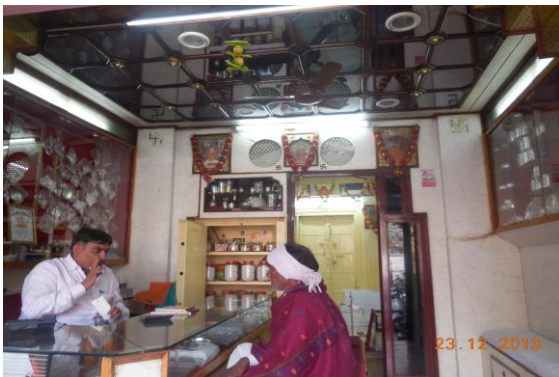
Photo 66

All Walls of Shop No.16 of Ground Floor Covered With Glass Work

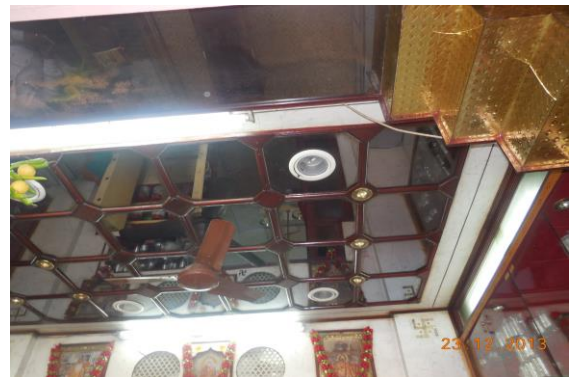
Photo 67

All Walls of Part A+B of Shop No.15 of Ground Floor Covered With Wooden Work

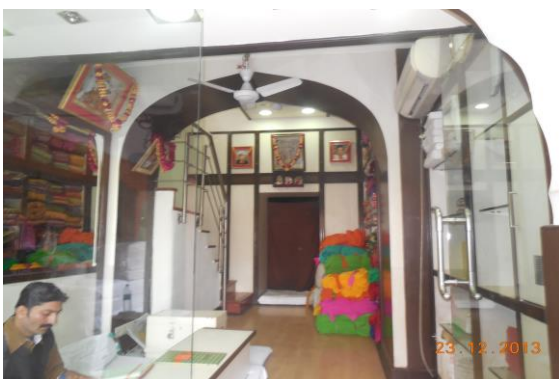
Photo 68

Roof of Part A of Shop No.15 of Ground Floor Covered With Glass Work

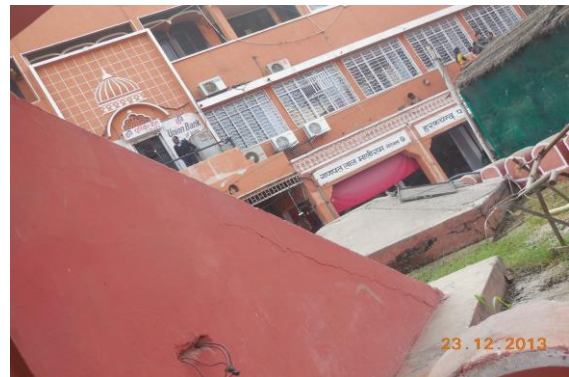
Photo 4
Horizontal Crack on Outside Wall No.2 of Staircase, Ground Floor
Approx. Width = 0.4mm, Approx. Length = 1.5m. Distance from Main Gate = 2m, Height from Floor = 0m.

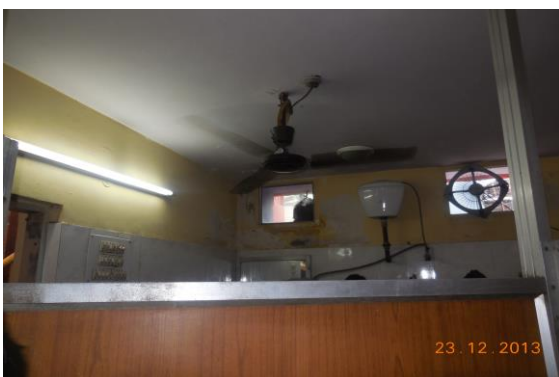
Photo 5
Dampness/Seepage on Wall No. 1 of Gents Toilet of Ground Floor

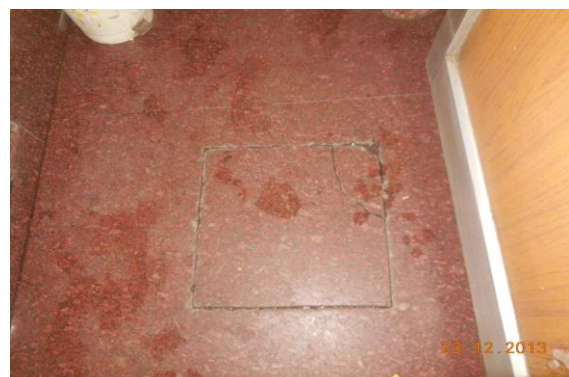
Photo 6
Damaged Portion on Floor of Chamber of Ground Floor

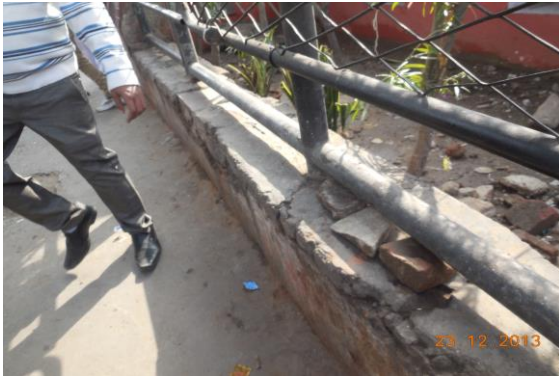
Photo 7

Damaged Portion on Rightside Wall of Parapet Wall of Ground Floor

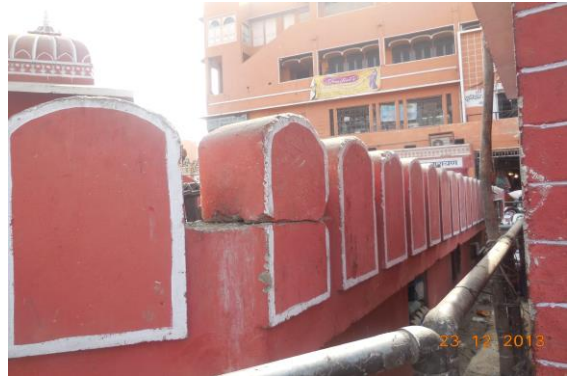
Photo 8

Damaged Portion on Backside of Parapet Wall of Ground Floor

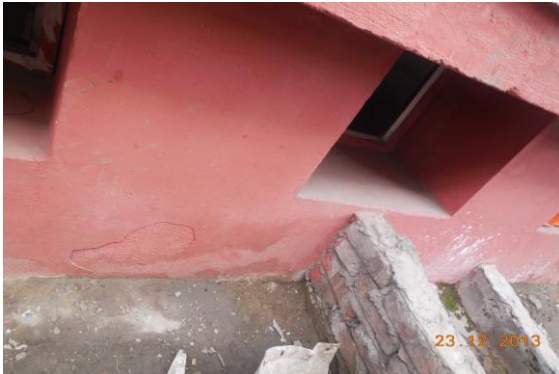
Photo 9

Peeling of Plaster on Outside Wall of Parapet Wall of Ground Floor

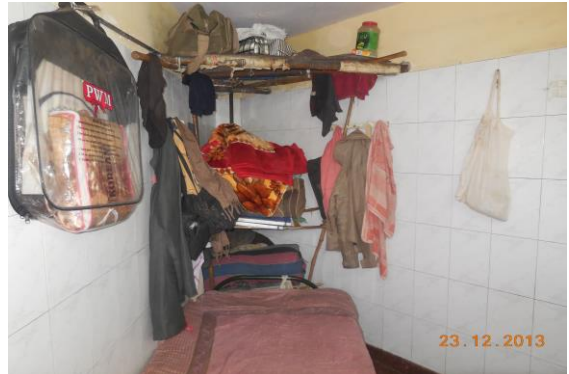
Photo 10

All Walls of Office of Ground Floor Covered With Tiles

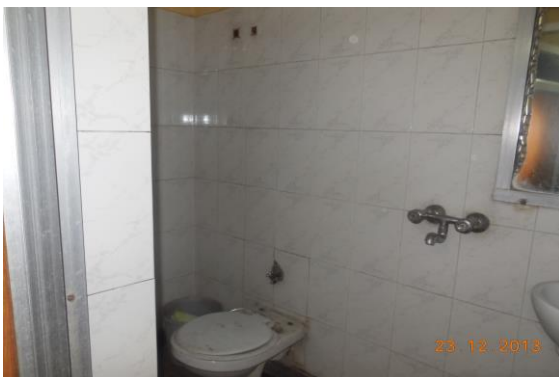
Photo 11

All Walls of Ladies Toilet of Ground Floor Covered With Tiles

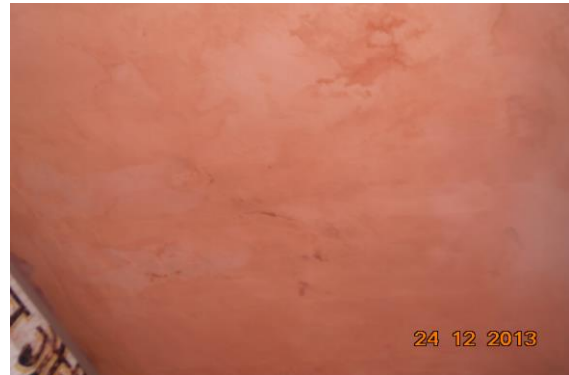
Photo 8

Summary of Defects Other Than Crack			
Defect ID	Location	Description	Photo No.
1	Roof Varanda of Shop of Manmal Gori Shankar	Peeling of Plaster	8
2	Roof Varanda of Shop Mahaluxmi Saree Emporium Ground Floor	Peeling of Plaster	9

Peeling of Plaster on Roof of Varanda Shop of Manmal Gori Shankar

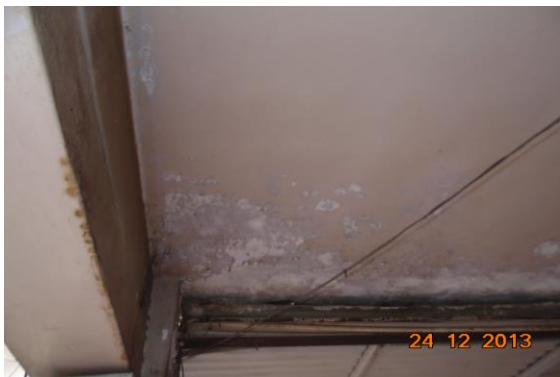
Photo 9

Peeling of Plaster on Roof of Varanda of Shop Mahaluxmi Saree Emporium of Ground Floor

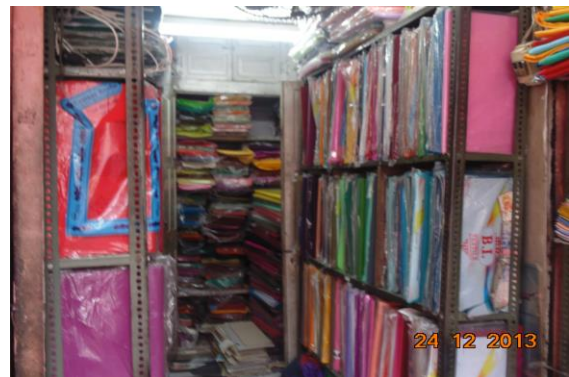
Photo 10

All Walls of Shop of Manmal Gori Shankar of Ground Floor Covered With Material

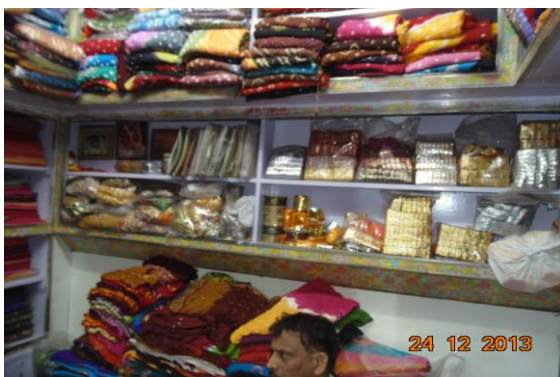
Photo 11

Rightside of Shop No.2 of Ground Floor Covered With Cloth

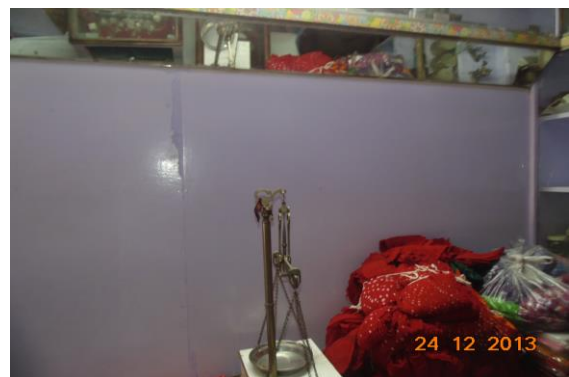
Photo 12

Leftside of Shop No.2 of Ground Floor Covered With Cloth

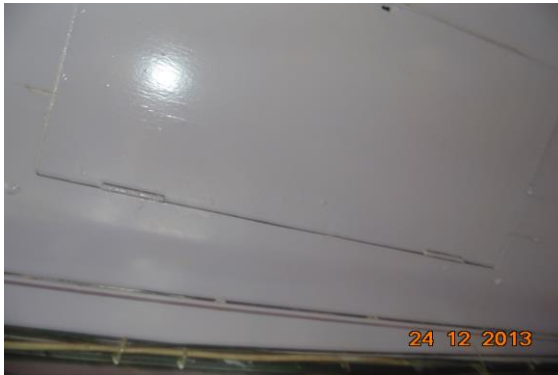
Photo 13

Roof of Shop No.2 of Ground Floor Covered With Wooden Work

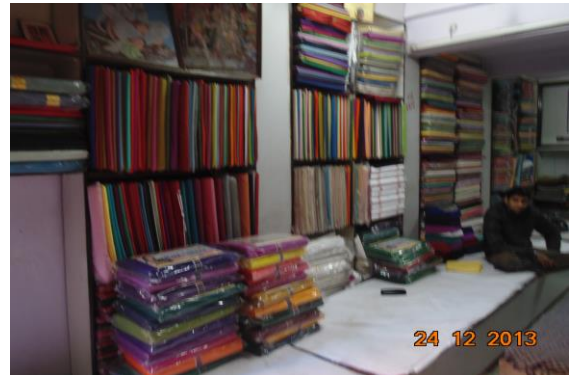
Photo 14

Wall No. 1 of Part A of Shop No.3 of Ground Floor Covered With Cloth

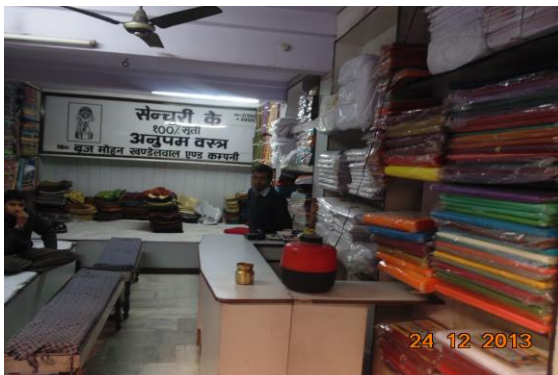
Photo 15

Wall No. 2 & 4 of Part A of Shop No.3 of Ground Floor Covered With Wooden Work

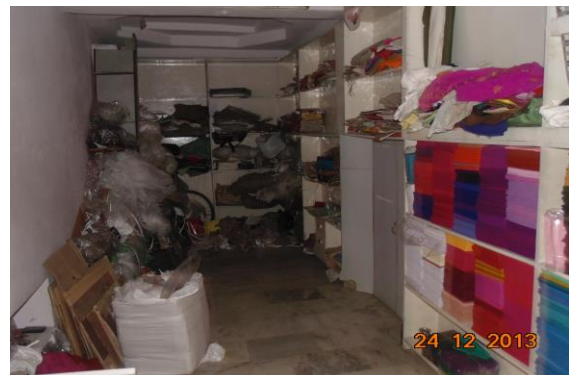
Photo 16

Wall No. 1 & 4 of Part B of Shop No.3 of Ground Floor Covered With Cloth

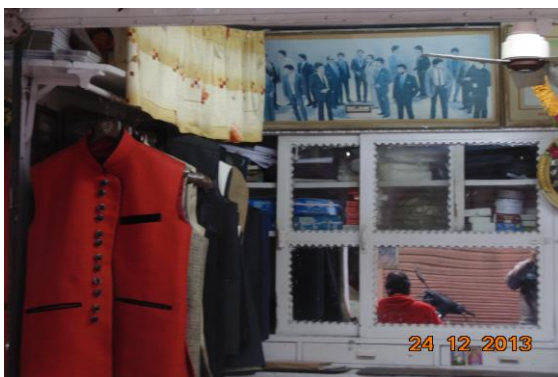
Photo 17

Wall No. 1 & 4 of Shop Gopi Radha Krishan Tailor of Ground Floor Covered With Material

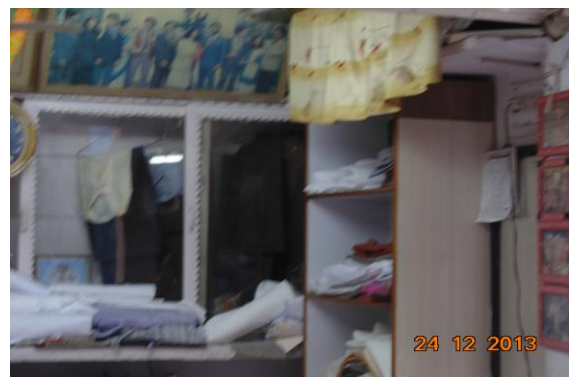
Photo 18

Wall No. 2 & 4 of Shop Gopi Radha Krishan Tailor of Ground Floor Covered With Material & Wooden Rack

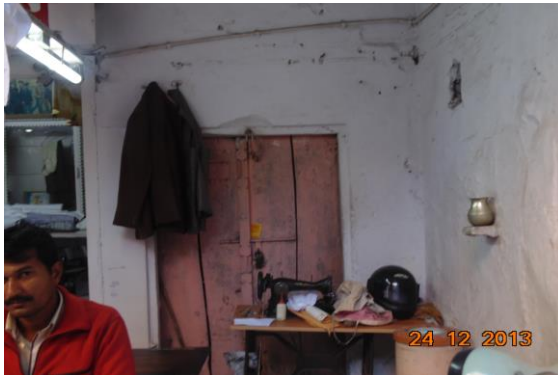
Photo 19
Godown Mohan Aggarwal of Ground Floor Locked

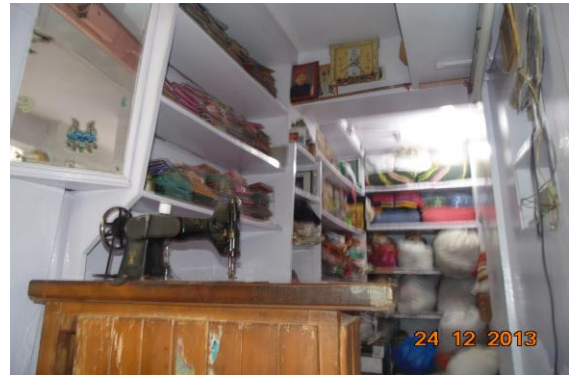
Photo 20
Wall No. 1 & 4 of Shop OM Saree Center of Ground Floor Covered With Material & Wooden Rack

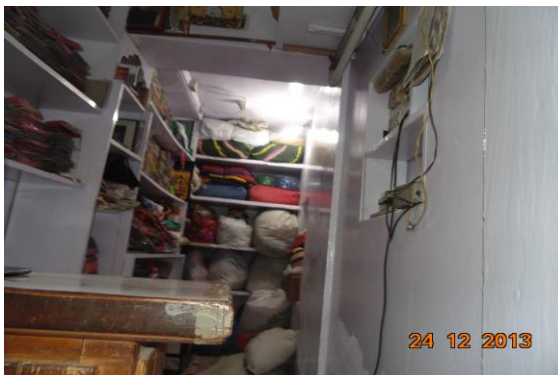
Photo 21
Wall No. 4 of Shop OM Saree Center of Ground Floor Covered With Material & Wooden Rack

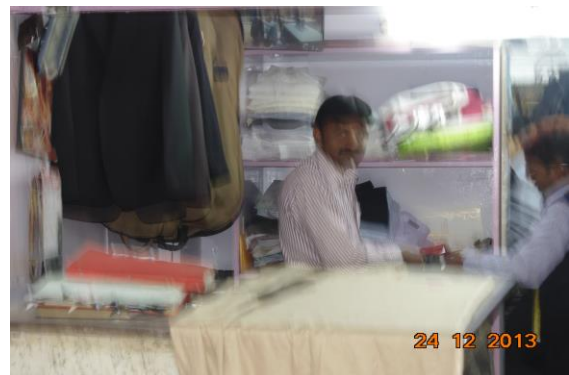
13	Wall No. 1 & 4 Shop Kishan Tailor Ground Floor	Covered With Cloth	22
14	Wall No. 2 & 4 Shop Kishan Tailor Ground Floor	Covered With Cloth	23
15	Wall No. 2 & 4 Shop Kishan Tailor Ground Floor	Covered With Cloth	24
16	Shop P.H Textile Ground Floor	Locked	25
17	Shop Munna Lal Taksali Saraf Ground Floor	Locked	26
18	All Walls Shop Prem Chand Ratan Chand Ground Floor	Covered With Material	27
19	Shop Mahaluxmi Saree Emporium Ground Floor	Locked	28

Photo 22
Wall No. 1 & 4 of Shop Kishan Tailor of Ground Floor Covered With Cloth
