Pre Building Condition Survey Report

Name and Address of Structure :	Badi Chopar Station Area
---------------------------------	--------------------------

Name of the Project	Contract JMRC-UG1B “Design and Construction of Tunnel between Chandpole and Badi Chouper and reverse line by Shield TBM, Underground Metro Stations at Choti Chouper and Badi Chouper by Cut and Cover Methods on East West Corridor of Jaipur Metro Rail Corporation Limited .”	
Owner :

Pre - Condition Building Survey for Construction of Underground Stations from Chandpole to Bari Chouper and reversal line

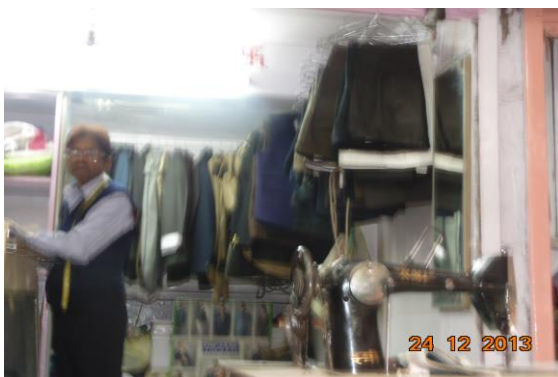
13	Wall No. 1 & 4 Shop Kishan Tailor Ground Floor	Covered With Cloth	22
14	Wall No. 2 & 4 Shop Kishan Tailor Ground Floor	Covered With Cloth	23
15	Wall No. 2 & 4 Shop Kishan Tailor Ground Floor	Covered With Cloth	24
16	Shop P.H Textile Ground Floor	Locked	25
17	Shop Munna Lal Taksali Saraf Ground Floor	Locked	26
18	All Walls Shop Prem Chand Ratan Chand Ground Floor	Covered With Material	27
19	Shop Mahaluxmi Saree Emporium Ground Floor	Locked	28

Photo 23
Wall No. 2 & 4 of Shop Kishan Tailor of Ground Floor Covered With Cloth

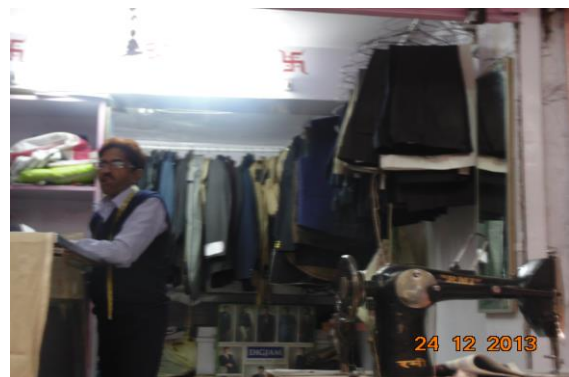
Photo 24
Wall No. 2 & 4 of Shop Kishan Tailor of Ground Floor Covered With Cloth

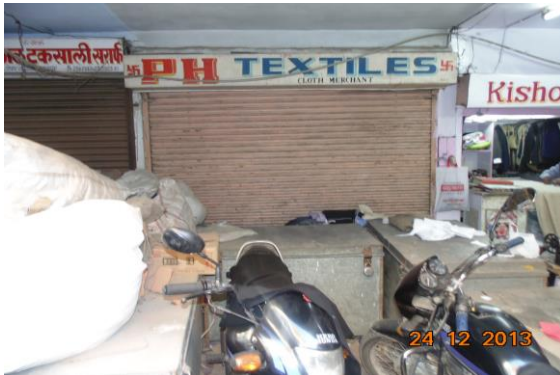
Photo 25
Shop P.H Textile of Ground Floor Locked

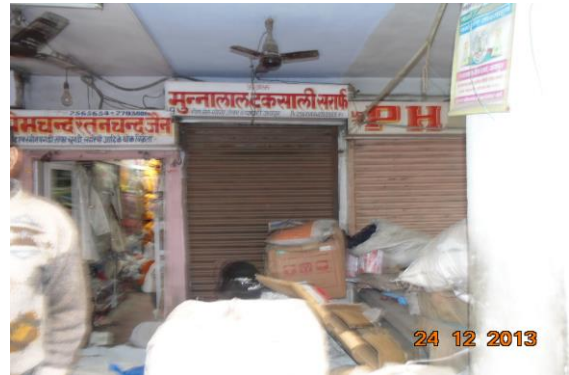
Photo 26
Shop Munna Lal Taksali Saraf of Ground Floor Locked

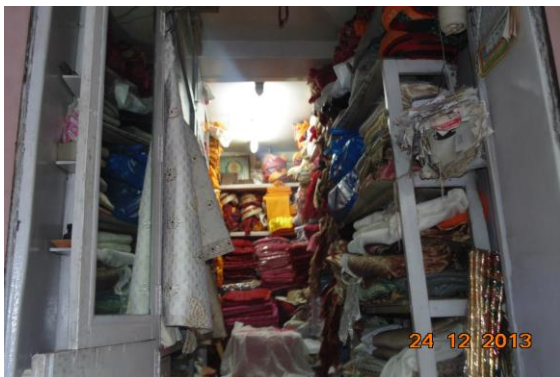
Photo 27
All Walls of Shop Prem Chand Ratan Chand of Ground Floor Covered With Material

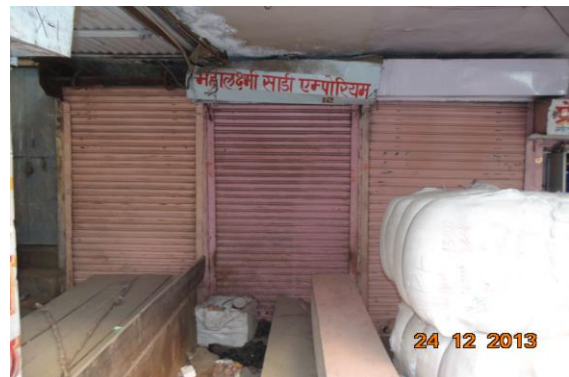
Photo 28
Shop Mahaluxmi Saree Emporium of Ground Floor Locked

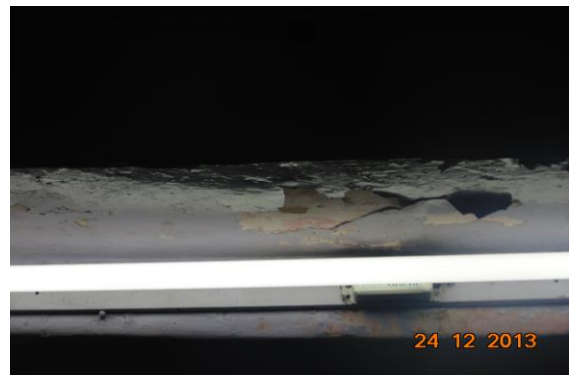
Summary of Defects Other Than Crack			
Defect ID	Location	Description	Photo No.
1	Roof Shop Jagdish Narain Badri Prasad Ground Floor	Peeling of Plaster	4

Photo 4
Peeling of Plaster on Roof of Shop Jagdish Narain Badri Prasad of Ground Floor

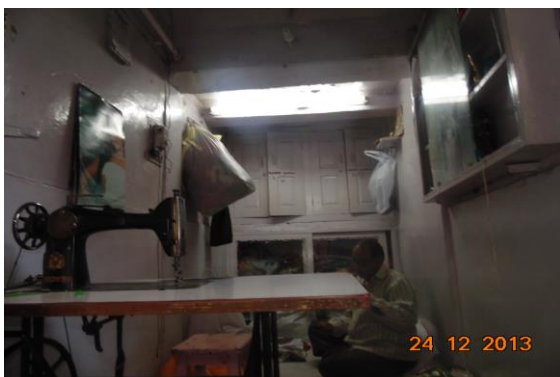
Summary of Areas that Could not be Surveyed			
Serial No.	Location	Description	Photo No.
1	Wall No. 1 Shop Jagdish Narain Badri Prasad Ground Floor	Covered With Wooden Almira	5

Photo 5
Wall No. 1 of Shop Jagdish Narain Badri Prasad of Ground Floor
Covered With Wooden Almira

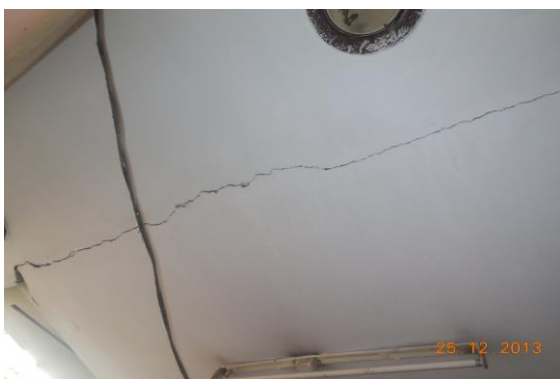
Summary of Cracks						
Defect ID	Location	Orientation	Appx. Width (mm)	Appx. Length (m)	Category	Photo No.
1	Corridor Part 4 Gyarah Rudrah Mandir of First floor	Inclined	5	6	Moderate	5

Photo 5
Inclined Crack on Corridor, Part 4 Gyarah Rudra Mandir of First floor, Approx. Width = 5mm, Approx. Length = 6m.
Distance from Main Door = 1m, Height from Floor = 3m.

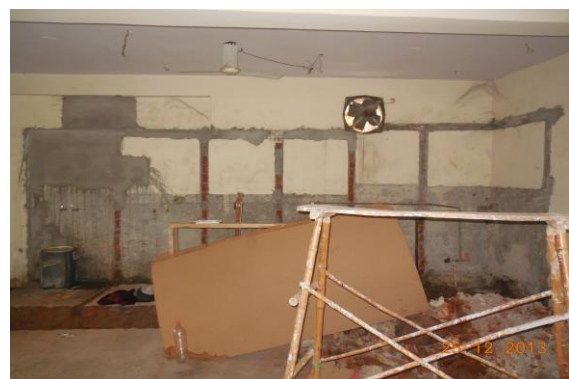
Summary of Defects Other Than Crack			
Defect ID	Location	Description	Photo No.
2	Wall No. 4 Hall No. 1 First floor	Peeling of Plaster	6
3	Part 4 Gyarah Rudrah Mandir Ground Floor	Exposed Reinforcement	7

Photo 6
Peeling of Plaster on Wall No. 4 of Hall No. 1 of First floor

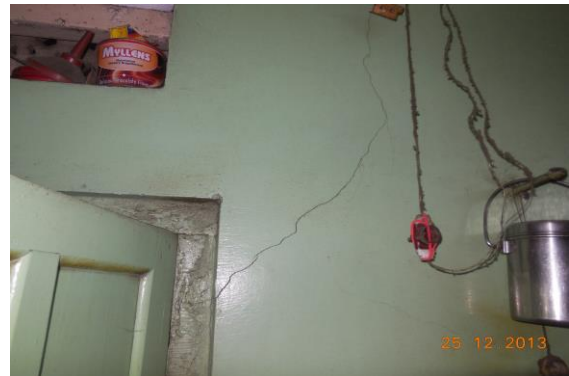
Summary of Cracks						
Defect ID	Location	Orientation	Appx. Width (mm)	Appx. Length (m)	Category	Photo No.
1	Wall No. 3 Room No. 4 Part 3 Gyarah Rudrah Mandir, Second Floor	Inclined	1	0.6	Slight	20
2	Wall No. 3 Room No. 4 Part 3 Gyarah Rudrah Mandir, Second Floor	Inclined	1	0.6	Slight	21
3	Wall No. 4 Room No. 4 Part 3 Gyarah Rudrah Mandir, Second Floor	Horizontal	0.8	0.9	Very Slight	22
4	External Wall Back Side	Inclined	1.6	2.6	Slight	23

Photo 20
Inclined Crack on Wall No. 3 of Room No. 4, Part 3 Gyarah Rudra Mandir, Second Floor, Approx. Width = 1mm, Approx. Length = 0.6m. Distance from Wall No. 2 = 2m, Height from Floor = 1.7m.

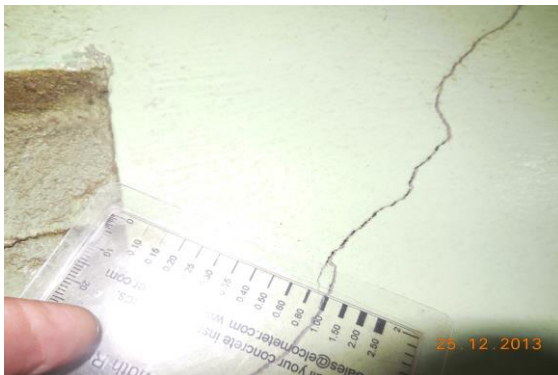
Photo 21
Inclined Crack on Wall No. 3 of Room No. 4, Part 3 Gyarah Rudra Mandir, Second Floor, Approx. Width = 1mm, Approx. Length = 0.6m. Distance from Wall No. 2 = 2m, Height from Floor = 1.7m.

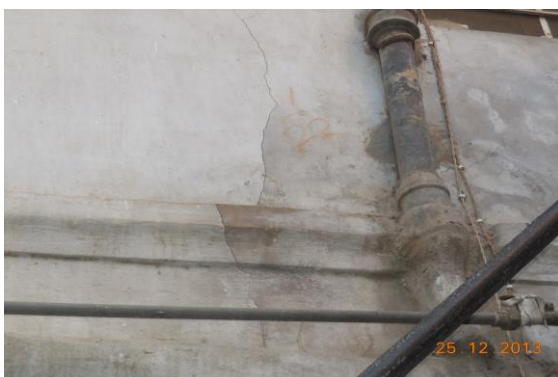
Photo 23
Inclined Crack on External Wall of Back Side, Approx. Width = 1.6mm, Approx. Length = 2.6m. Distance from Shop No. 1 = 1.8m, Height from Floor = 1.6m.

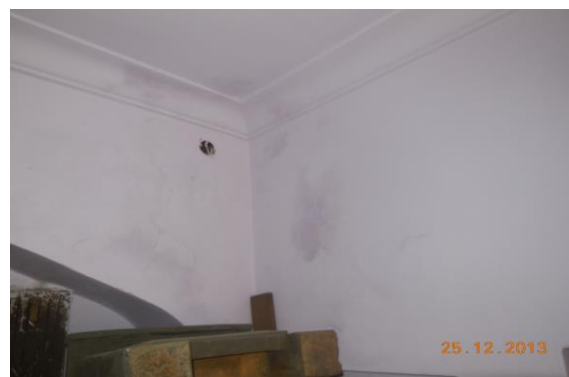
Summary of Defects Other Than Crack			
Defect ID	Location	Description	Photo No.
5	Wall No. 1 & 3 Shop No. 9 First floor	Dampness/Seepage	24
6	Wall No. 3, 4 & Roof Lobby Shop No. 10 & 11, First Floor	Peeling of Plaster	25
7	Wall No. 3, 4 & Roof Lobby Shop No. 10 & 11, First Floor	Peeling of Plaster	26
8	Wall No. 3 & Roof Room No. 4 Part 3 Gyarah Rudrah Mandir, Second Floor	Dampness/Seepage	27
9	Wall No. 4 Room No. 4 Part 3 Gyarah Rudrah Mandir, Second Floor	Dampness/Seepage	28
10	Roof Room No. 4 Part 3 Gyarah Rudrah Mandir, Second Floor	Peeling of Plaster	29
11	Wall No. 1 Part 3 Gyarah Rudrah Mandir Ground Floor Shed	Peeling of Plaster	30
12	Wall No. 1 & 4 Part 3 Gyarah Rudrah Mandir Ground Floor Shed	Peeling of Plaster	31
13	Wall No. 4 Varanda Part 3 Gyarah Rudrah Mandir, Ground Floor Shed	Peeling of Plaster	32
14	Roof Varanda Part 3 Gyarah Rudrah Mandir, Ground Floor Shed	Peeling of Plaster	33
15	Wall No. 1 & 3 Varanda Part 3 Gyarah Rudrah Mandir, Ground Floor Shed	Peeling of Plaster	34

Photo 24
Dampness/Seepage on Wall No. 1 & 3 of Shop No. 9 of First floor

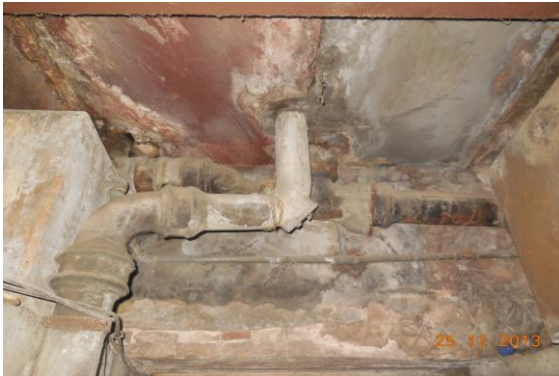
Photo 25

Peeling of Plaster on Wall No. 3, 4 & Roof of Lobby of Shop No. 10 & 11, First Floor

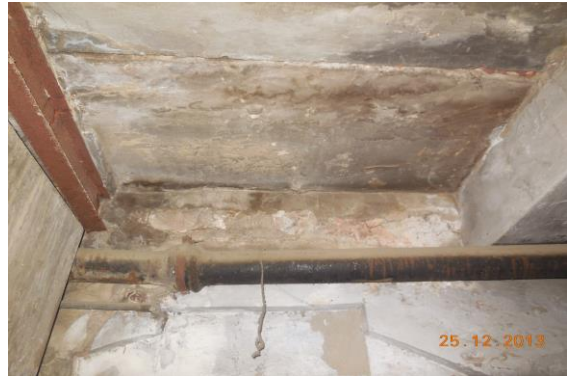
Photo 26

Peeling of Plaster on Wall No. 3, 4 & Roof of Lobby of Shop No. 10 & 11, First Floor

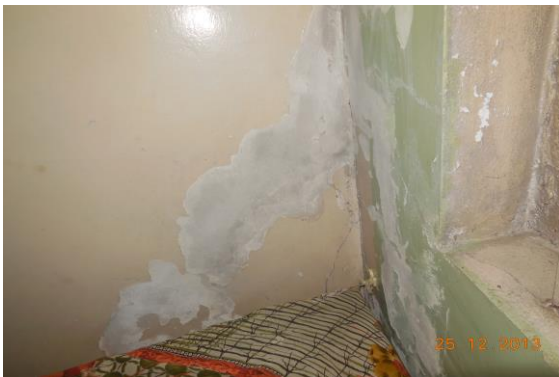
Photo 27

Dampness/Seepage on Wall No. 3 & Roof of Room No. 4 of Part 3 Gyarah Rudrah Mandir, Second Floor

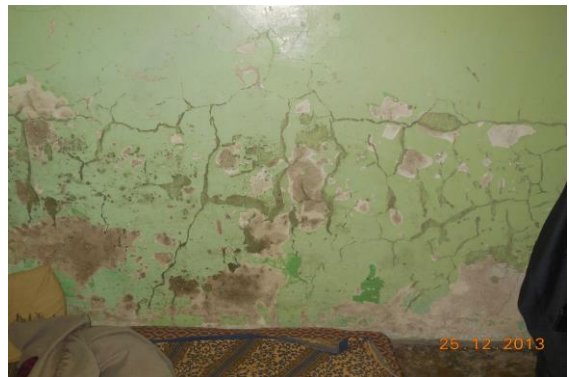
Photo 28

Dampness/Seepage on Wall No. 4 of Room No. 4 of Part 3 Gyarah Rudrah Mandir, Second Floor

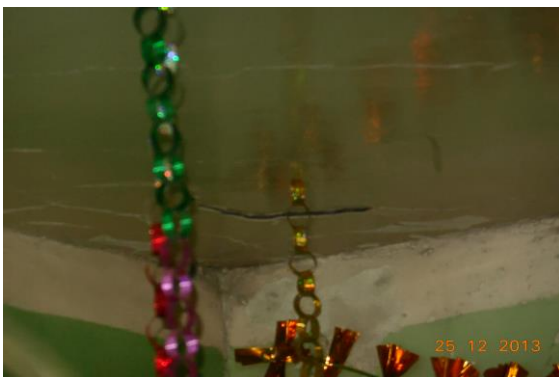
Photo 29

Peeling of Plaster on Roof of Room No. 4 of Part 3 Gyarah Rudrah Mandir, Second Floor

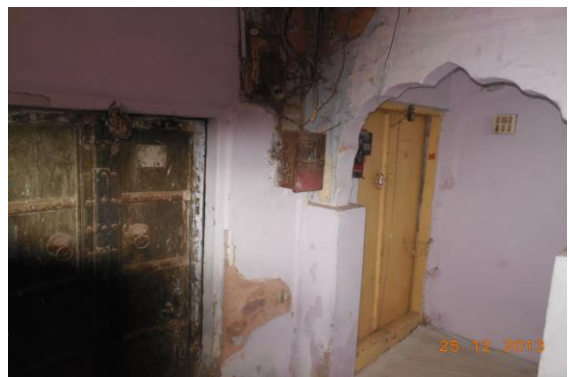
Photo 30

Peeling of Plaster on Wall No. 1 of Part 3 Gyarah Rudrah Mandir of Ground Floor Shed

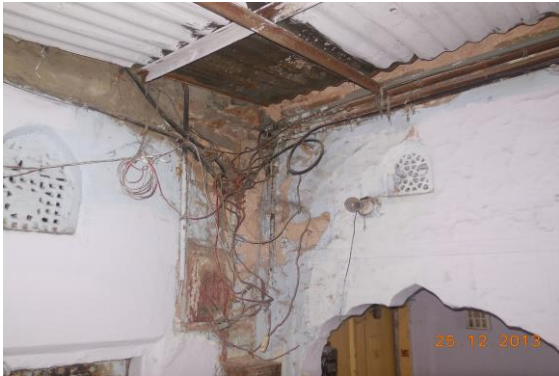
Photo 31

Peeling of Plaster on Wall No. 1 & 4 of Part 3 Gyarah Rudrah Mandir of Ground Floor Shed

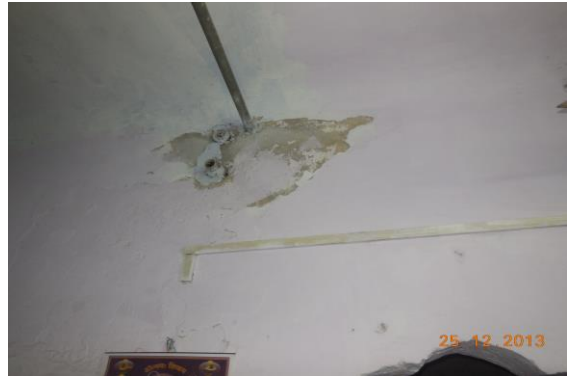
Photo 32

Peeling of Plaster on Wall No. 4 of Varanda of Part 3 Gyarah Rudrah Mandir, Ground Floor Shed

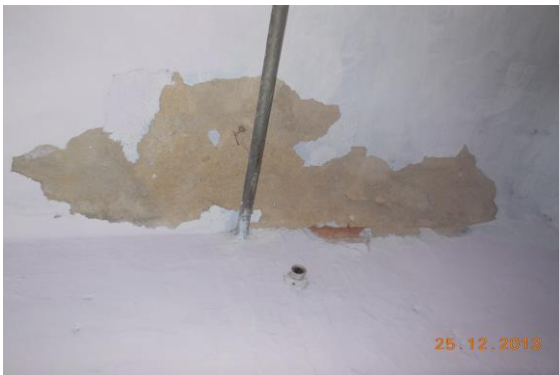
Photo 33

Peeling of Plaster on Roof of Varanda of Part 3 Gyarah Rudrah Mandir, Ground Floor Shed

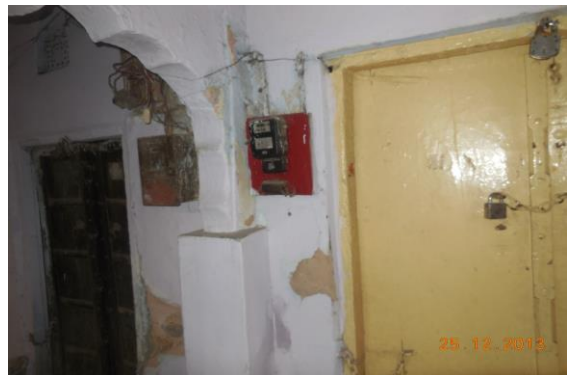
Photo 34

Peeling of Plaster on Wall No. 1 & 3 of Varanda of Part 3 Gyarah Rudrah Mandir, Ground Floor Shed

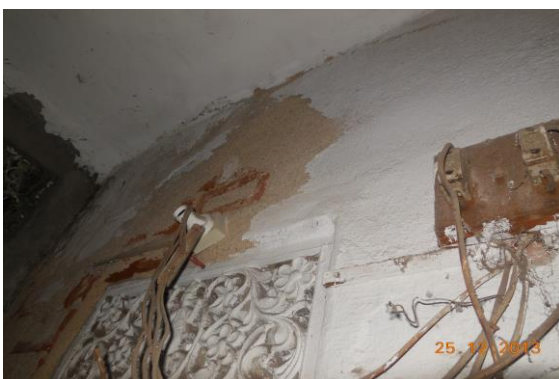
Photo 35

Peeling of Plaster on Wall No. 2 of Lobby of Part 3 Gyarah Rudrah Mandir, Ground Floor Shed

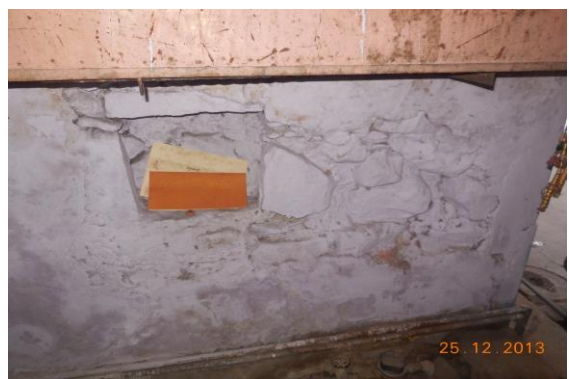
Photo 36

Peeling of Plaster on Wall No. 2 of Shop No. 1 of Ground Floor

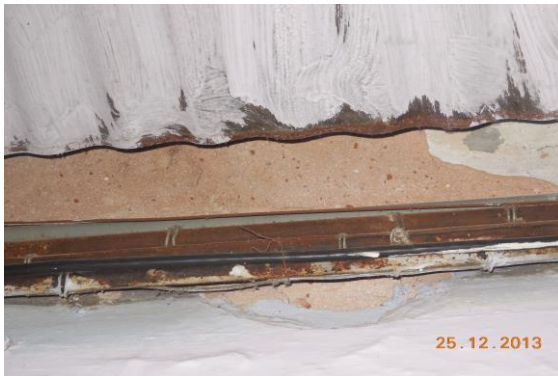
Photo 37
Peeling of Plaster on Wall No. 4 of Shop No. 1 of Ground Floor

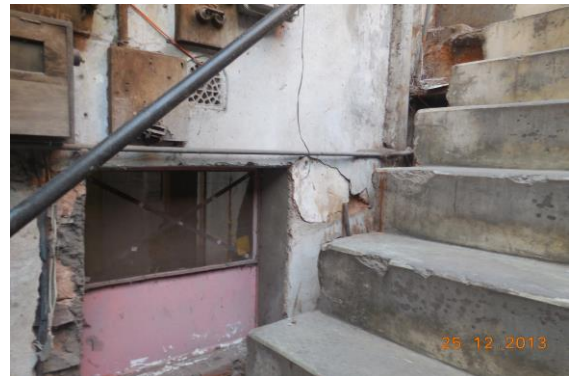
Photo 38
Peeling of Plaster on External Wall of Back Side of Gyarah Rudrah Mandir

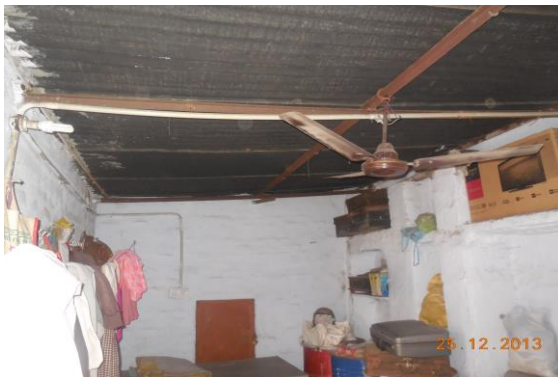
Photo 4
Inclined Crack on Wall No. 2 of Room No. 1, Second Floor, Approx.
Width = 0.6mm, Approx. Length = 0.6m.
Distance from Wall no.4 = 2.8m, Height from Floor = 1.8m.

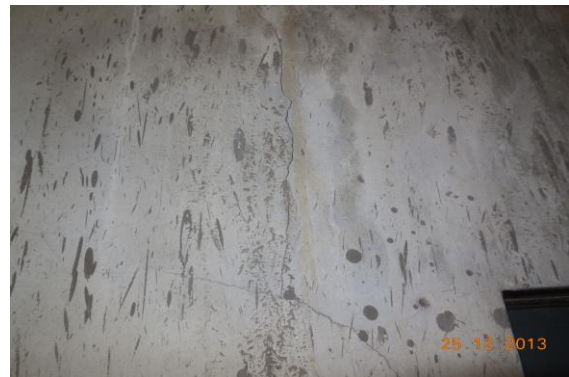
Photo 4A
Inclined Crack on Wall No. 2 of Room No. 1, Second Floor, Approx.
Width = 0.6mm, Approx. Length = 0.6m.
Distance from Wall no.4 = 2.8m, Height from Floor = 1.8m.

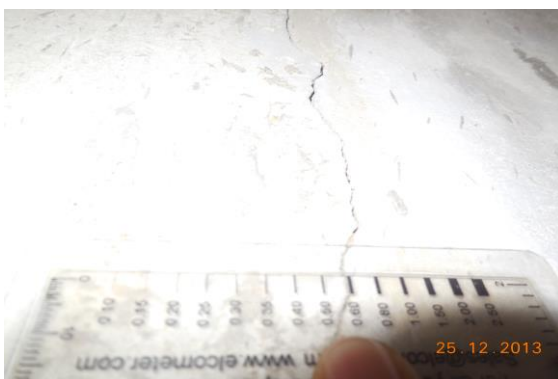
Photo 5
Horizontal Crack on Wall No. 1 of Room No. 1, Second Floor, Approx.
Width = 0.4mm, Approx. Length = 0.4m.
Distance from = Wall No.1 & 4 Cornern, Height from Floor = 1.8m.

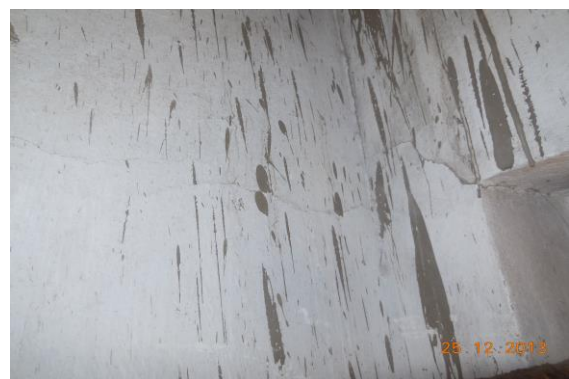
Photo 5A

Horizontal Crack on Wall No. 1 of Room No. 1, Second Floor, Approx.
Width = 0.4mm, Approx. Length = 0.4m.
Distance from = Wall No.1 & 4 Corner, Height from Floor = 1.8m.

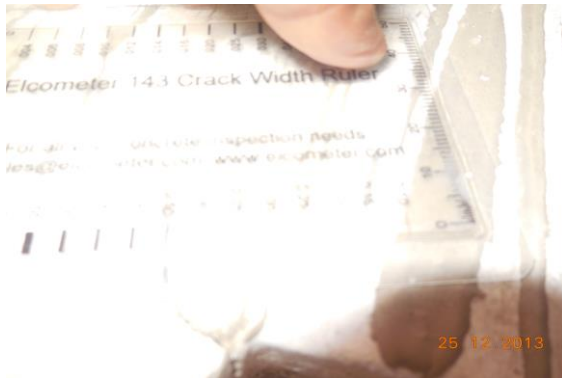
Photo 6

Vertical Crack on Wall No. 1 of Room No. 1, Second Floor, Approx.
Width = 0.4mm, Approx. Length = 2.6m.
Distance from Wall No.3 = 3m, Height from Floor = 0.1m.

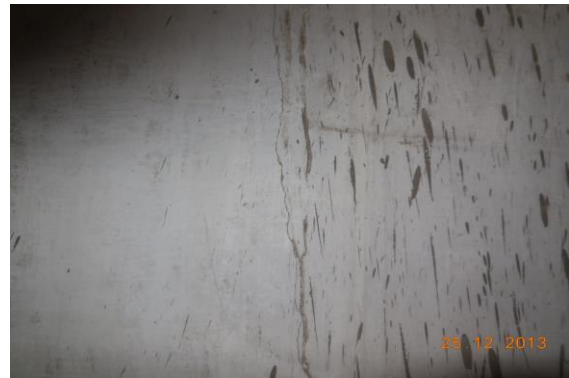
Photo 6A

Vertical Crack on Wall No. 1 of Room No. 1, Second Floor, Approx.
Width = 0.4mm, Approx. Length = 2.6m.
Distance from Wall No.3 = 3m, Height from Floor = 0.1m.

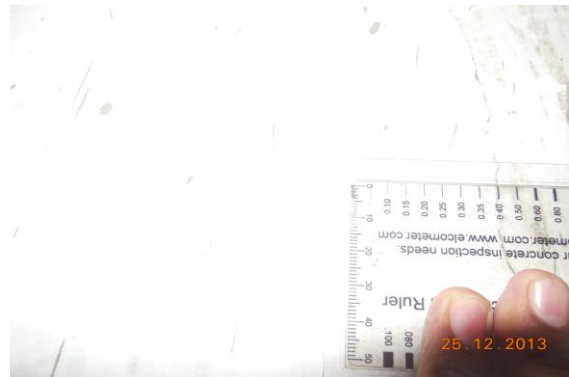
Photo 7

Vertical Crack on Wall No. 1 of Room No. 1, Second Floor, Approx.
Width = 0.35mm, Approx. Length = 1.5m.
Distance from Wall No.4 = 2.2m, Height from Floor = 0m.

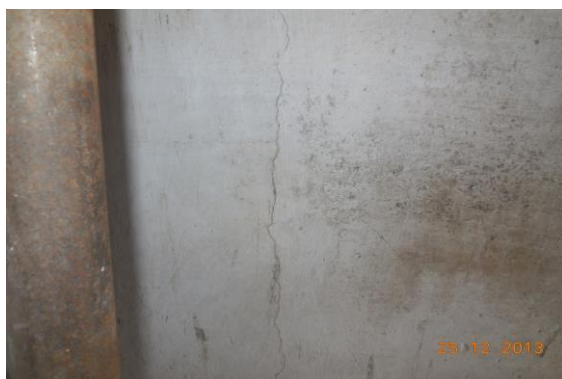
Photo 7A

Vertical Crack on Wall No. 1 of Room No. 1, Second Floor, Approx.
Width = 0.35mm, Approx. Length = 1.5m.
Distance from Wall No.4 = 2.2m, Height from Floor = 0m.

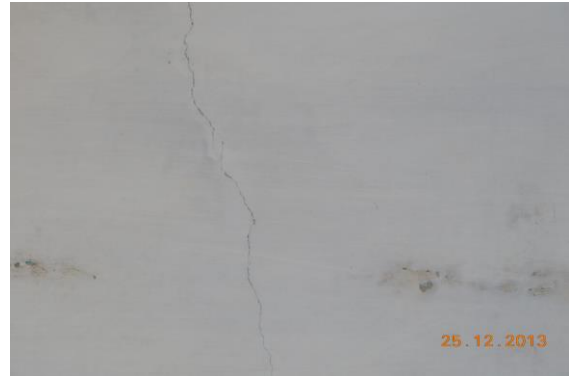
Photo 8

Inclined Crack on Wall No. 4 of Lobby, Second Floor, Approx. Width =
0.2mm, Approx. Length = 0.35m.
Distance from Wall no.1 = 0.3m, Height from Floor = 2m.

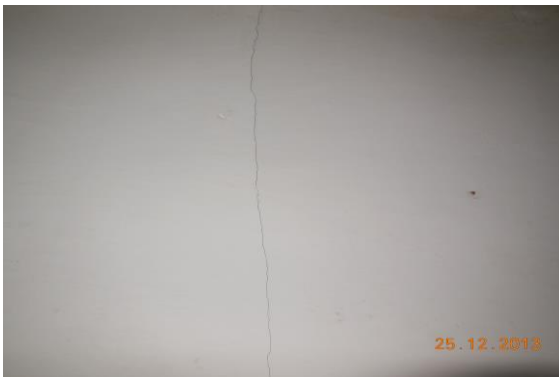
Photo 9

Vertical Crack on Wall No. 2 of Passage No.2, Second Floor, Approx.
Width = 0.2mm, Approx. Length = 1m.
Distance from Wall No.3 = 1.2m, Height from Floor = 1.5m.

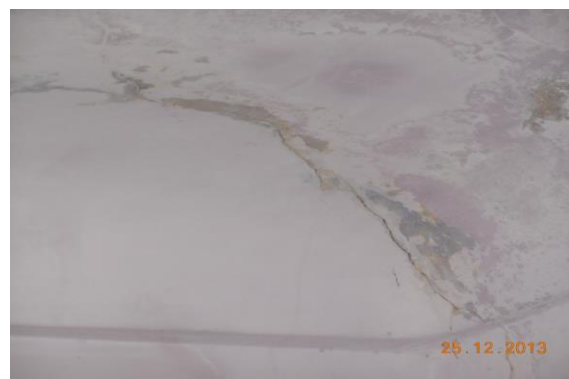
Photo 10

Inclined Crack on Wall No. 4 & Roof of , First Floor, Approx. Width =
3mm, Approx. Length = 3m.
Distance from = Corner Wall No.1 & 4m, Height from Floor = 1.5m.

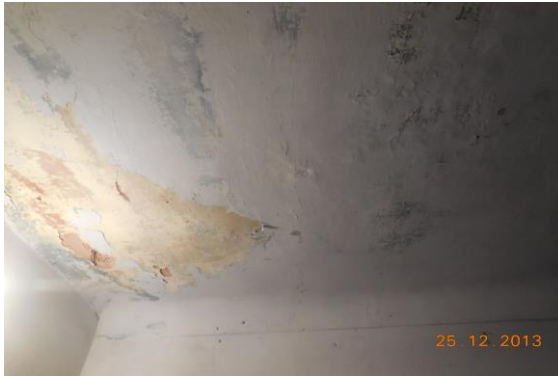
Photo 11
Dampness/Seepage on Roof of Lobby of Second Floor

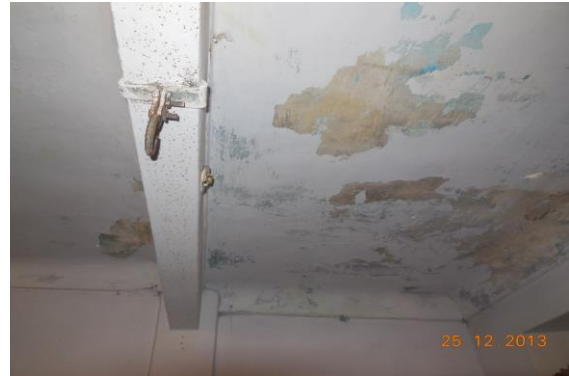
Photo 12
Dampness/Seepage on Roof of Lobby of Second Floor

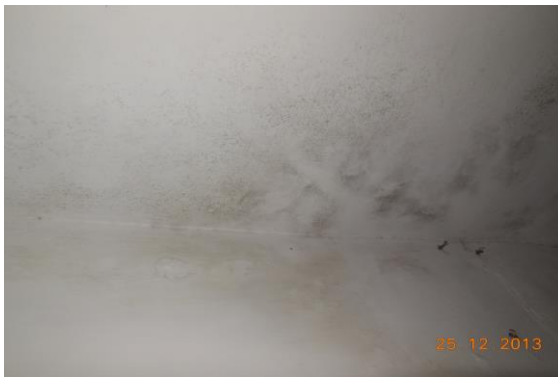
Photo 13
Dampness/Seepage on Roof of Passage No.2 of Second Floor

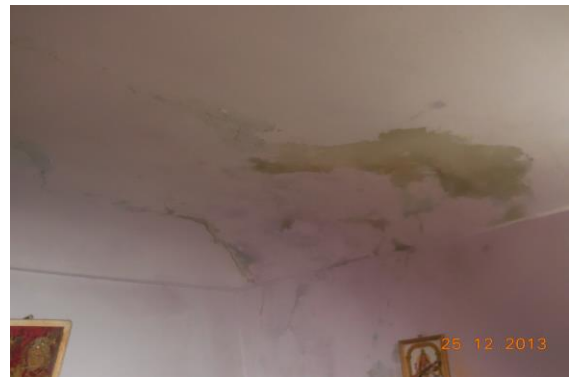
Photo 14
Dampness/Seepage on Roof of Varanda of First Floor

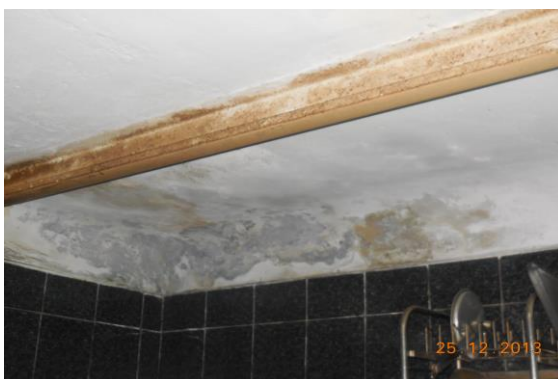
Photo 15
Dampness/Seepage on Roof & Wall No.4 of Kitchen of First Floor

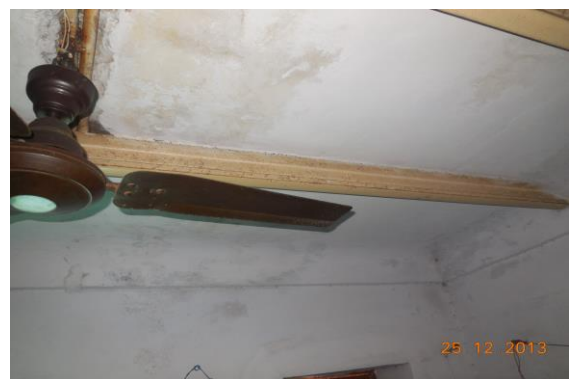
Photo 16
Dampness/Seepage on Roof & Wall No.4 of Kitchen of First Floor

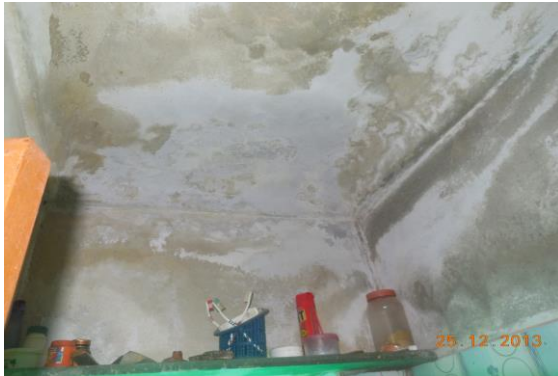
Photo 17

Dampness/Seepage on Wall No. 1, 4, 3 & Roof of Bathroom No. 1 of First Floor

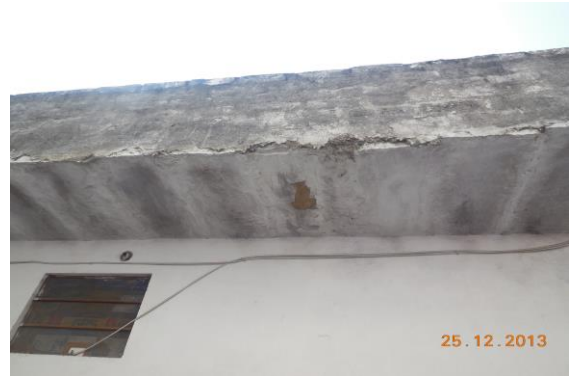
Photo 18

Dampness/Seepage on Roof of Tinsed of First Floor

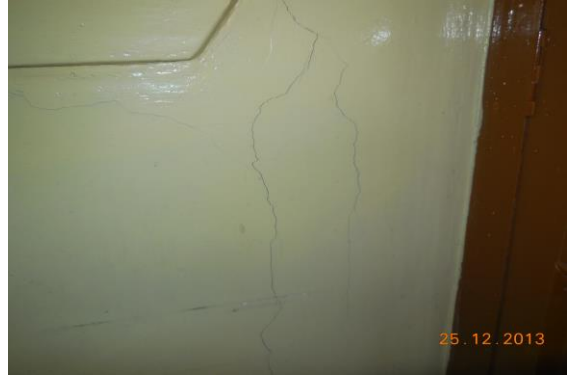
Photo 14

Vertical Crack on Wall No. 2 of Room No. 1, First Floor, Approx. Width = 0.4mm, Approx. Length = 1m.
Distance from Wall No.3 = 0.25m, Height from Floor = 0m.

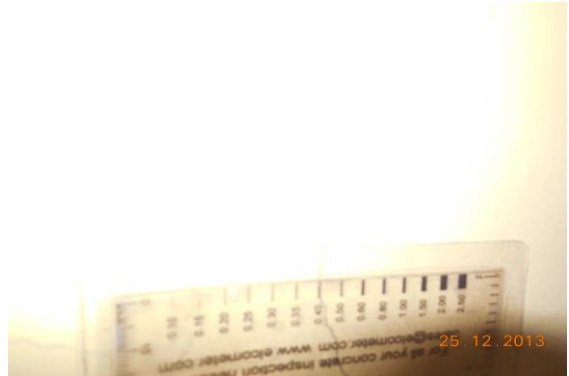
Photo 14A

Vertical Crack on Wall No. 2 of Room No. 1, First Floor, Approx. Width = 0.4mm, Approx. Length = 1m.
Distance from Wall No.3 = 0.25m, Height from Floor = 0m.

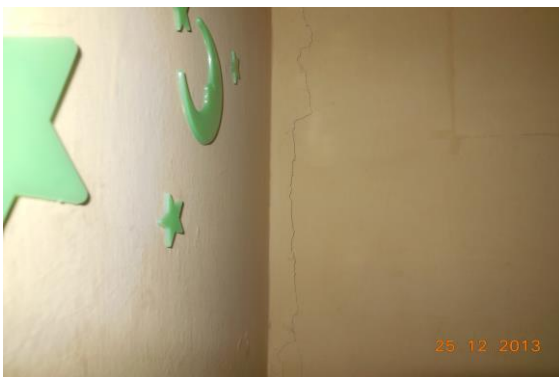
Photo 15

Vertical Crack on Wall No. 2 of Room No. 4, First Floor, Approx. Width = 0.35mm, Approx. Length = 2.5m.
Distance from = Corner Wall No.2 & 4m, Height from Floor = 0m.

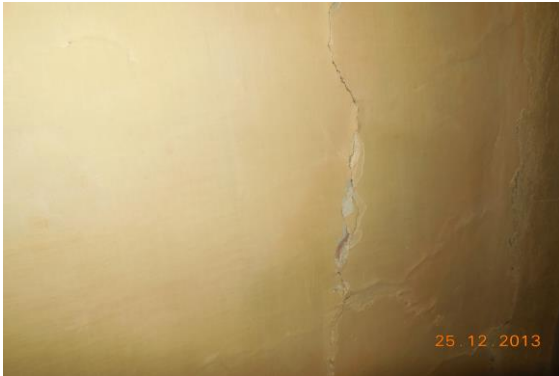
Photo 16

Vertical Crack on Wall No. 1 of Vijay Gopal Ji Temple, First Floor,
Approx. Width = 1mm, Approx. Length = 1.8m.
Distance from Wall No.2 = 2m, Height from Floor = 0m.

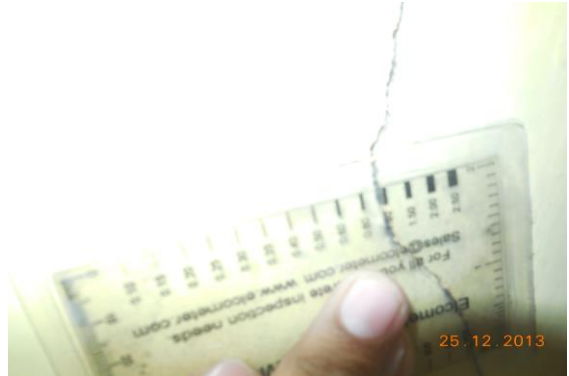
Photo 16A

Vertical Crack on Wall No. 1 of Vijay Gopal Ji Temple, First Floor,
Approx. Width = 1mm, Approx. Length = 1.8m.
Distance from Wall No.2 = 2m, Height from Floor = 0m.

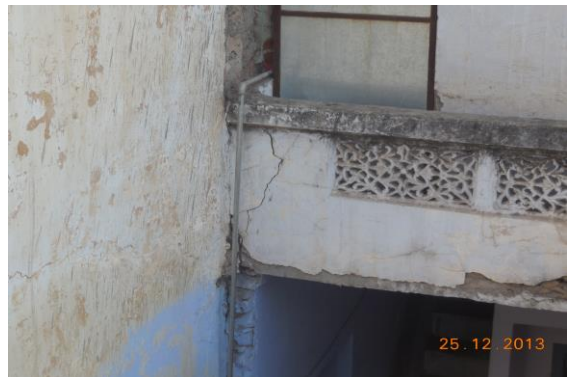
Photo 17

Inclined Crack on Wall No. 4 of Open Sky, First Floor, Approx. Width =
5mm, Approx. Length = 0.6m.
Distance from = Corner Wall No.1 & 4m, Height from Floor = 3m.

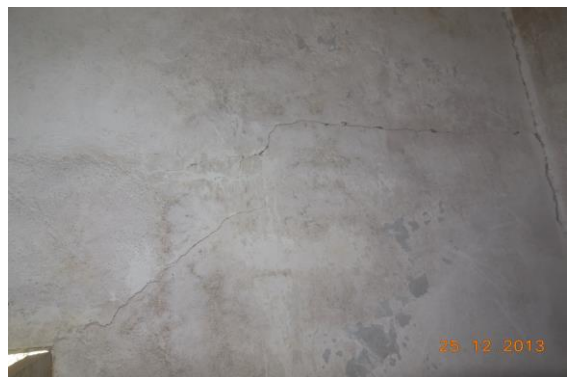
Photo 19

Inclined Crack on Wall No. 3 of Room No. 1, Second Floor, Approx.
Width = 0.4mm, Approx. Length = 1m.
Distance from Wall No.1 = 0m, Height from Floor = 1.7m.

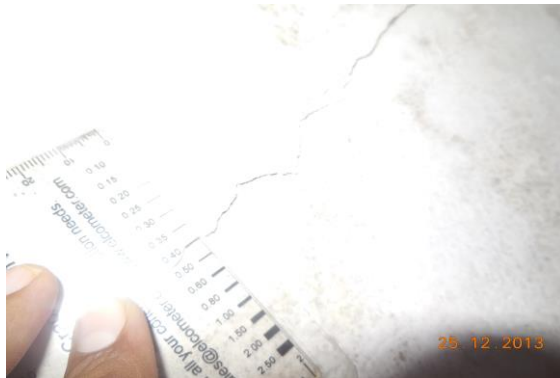
Photo 19A

Inclined Crack on Wall No. 3 of Room No. 1, Second Floor, Approx.
Width = 0.4mm, Approx. Length = 1m.
Distance from Wall No.1 = 0m, Height from Floor = 1.7m.

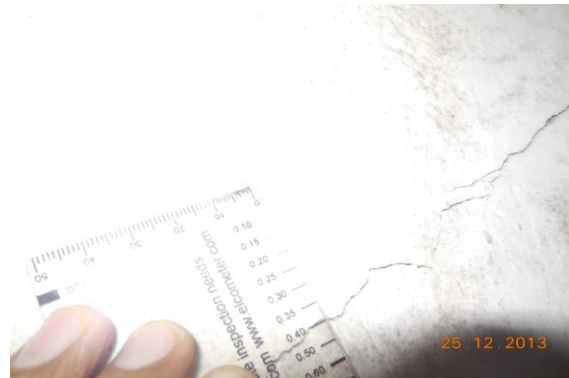
Photo 19A

Inclined Crack on Wall No. 3 of Room No. 1, Second Floor, Approx.
Width = 0.4mm, Approx. Length = 1m.
Distance from Wall No.1 = 0m, Height from Floor = 1.7m.

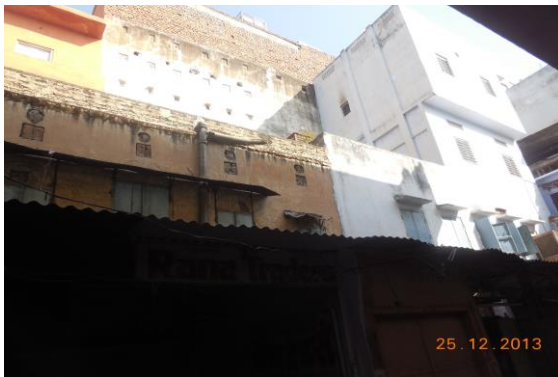
Photo 20

Vertical Crack on Vijay Gopal Ji Temple, Ground floor, Approx. Width =
1mm, Approx. Length = 3m.
Distance from = 5m, Height from Floor = 3m.

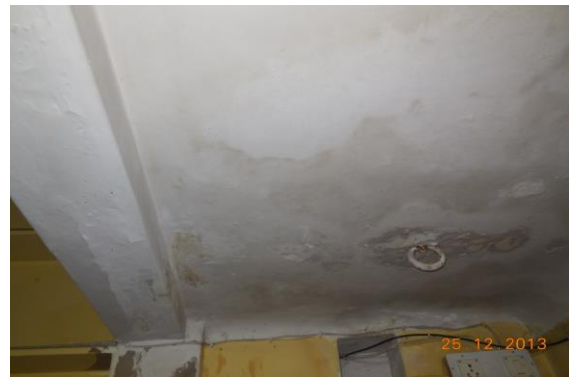
Photo 21

Dampness/Seepage on Wall No. 3 & Roof of Room No. 4 of First Floor

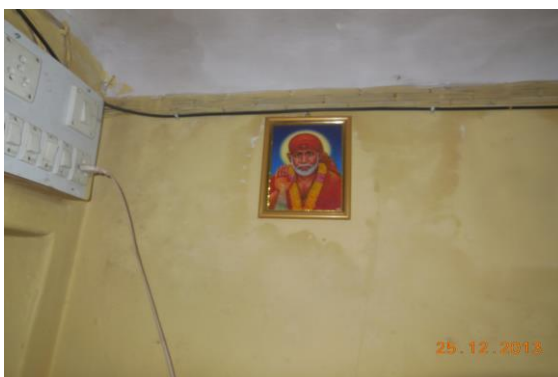
Photo 22

Dampness/Seepage on Wall No. 3 of Room No. 4 of First Floor

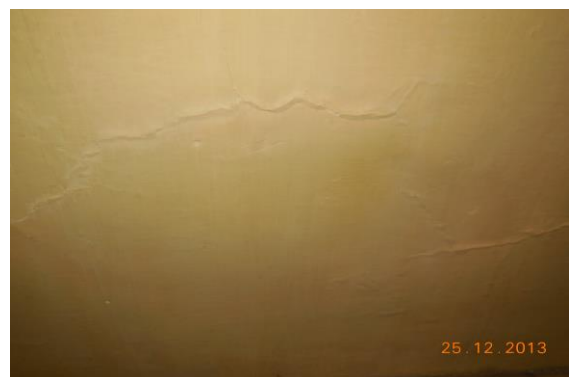
Photo 23

Peeling of Plaster on Wall No. 1 of Vijay Gopal Ji Temple of First Floor

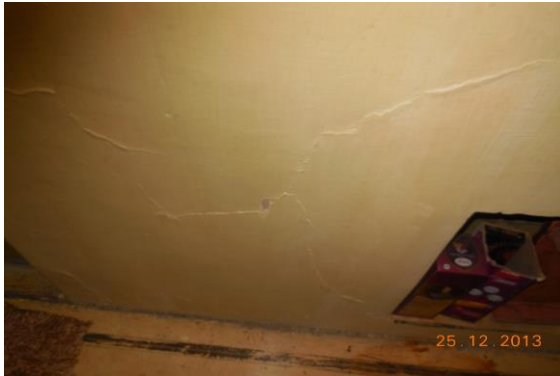
Photo 24

Peeling of Plaster on Wall No. 2 of Vijay Gopal Ji Temple of First Floor

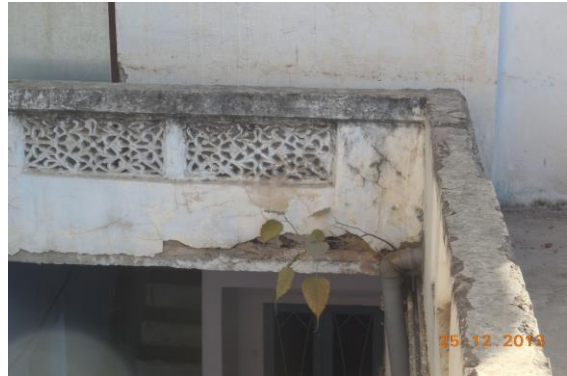
Photo 25

Peeling of Plaster on Wall No. 4 of Varanda of First Floor

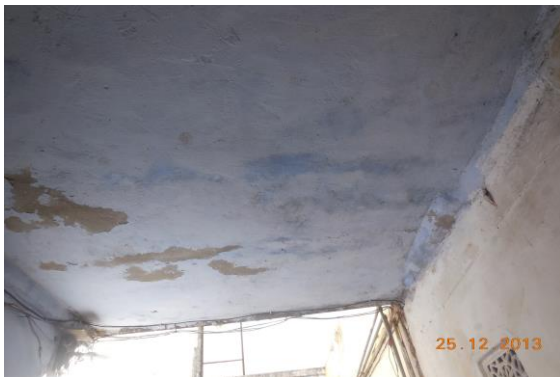
Photo 26

Peeling of Plaster on Wall No. 3 & Roof of Varanda of First Floor

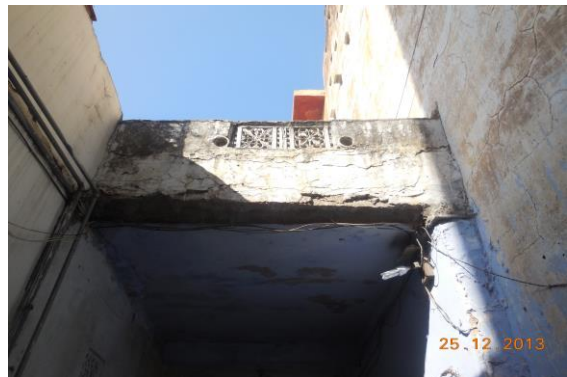
Photo 27

Peeling of Plaster on Wall No. 3 & Roof of Varanda of First Floor

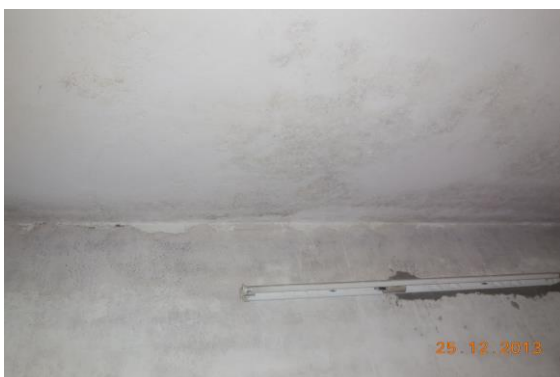
Photo 28

Dampness/Seepage on Wall No. 2 of Room No. 1 of Second Floor

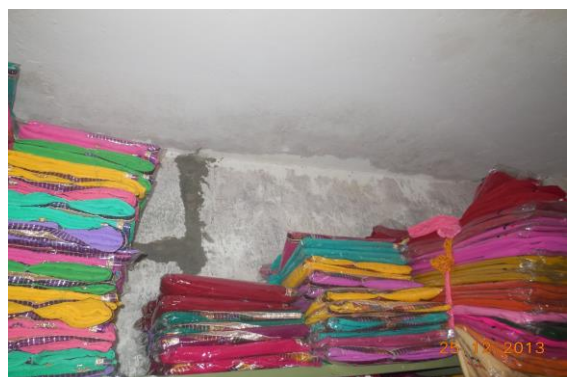
Photo 29

Dampness/Seepage on Wall No. 1 of Room No. 1 of Second Floor

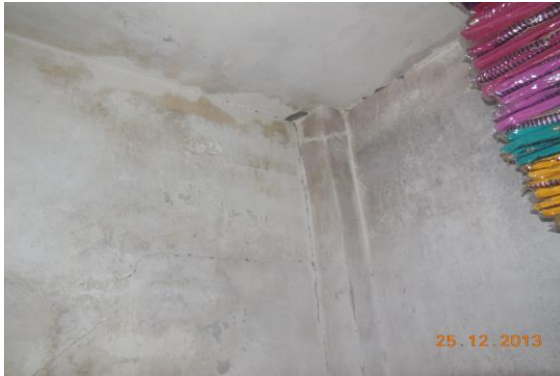
Photo 30

Dampness/Seepage on Wall No. 3 of Room No. 1 of Second Floor

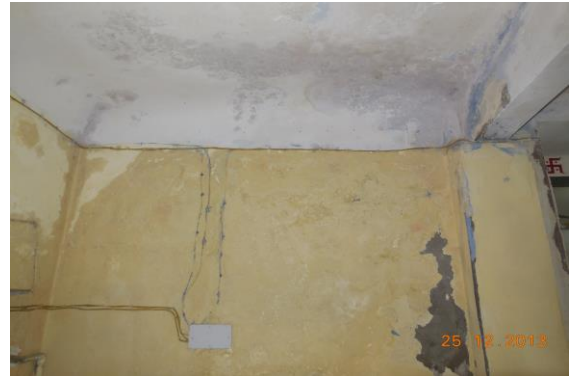
Photo 31

Dampness/Seepage on Wall No. 1 & Roof of Temple of Second Floor

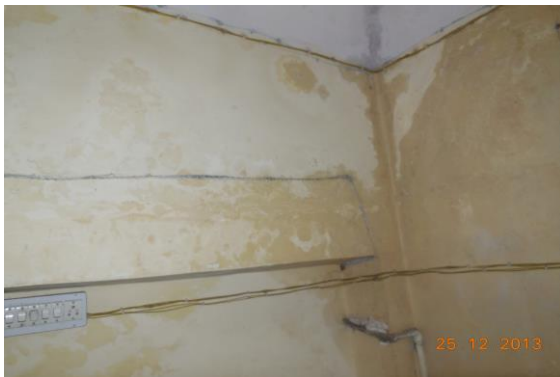
Photo 32

Dampness/Seepage on Wall No. 3 of Temple of Second Floor

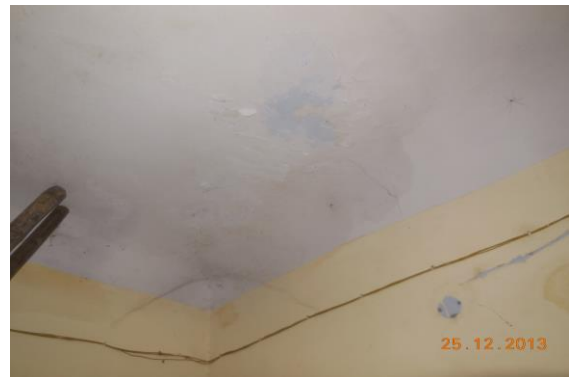
Photo 33

Peeling of Plaster on Roof of Vijay Gopal Ji Temple of Second Floor

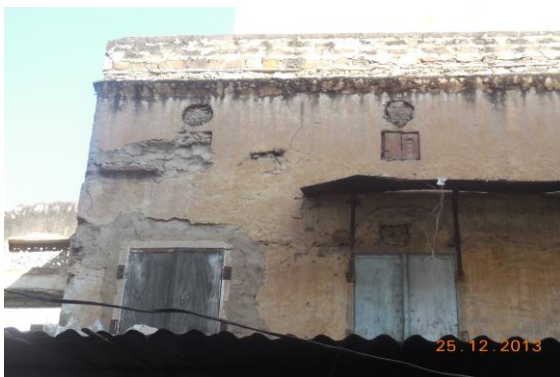
Photo 34

Peeling of Plaster on Outer Wall of Vijay Gopal Ji Temple of Ground floor

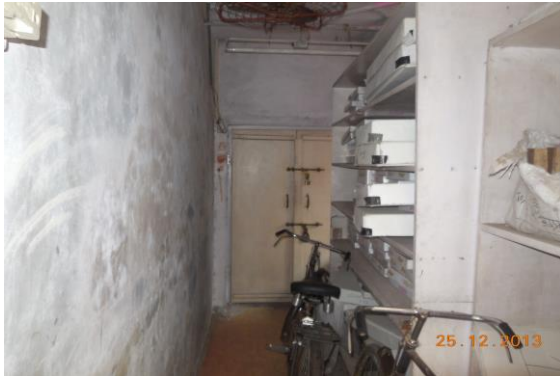
Photo 54
Godown No.3 of Ground floor Locked

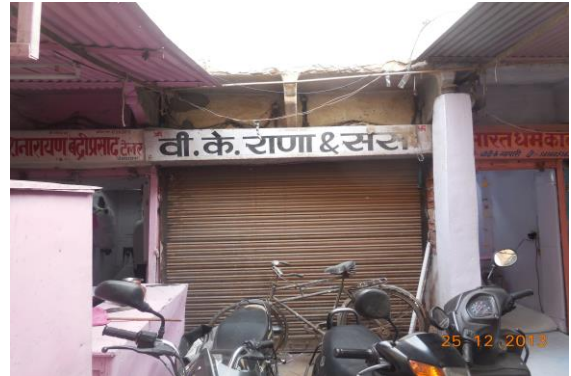
Photo 55
Shop V.K.Rana of Ground floor Locked

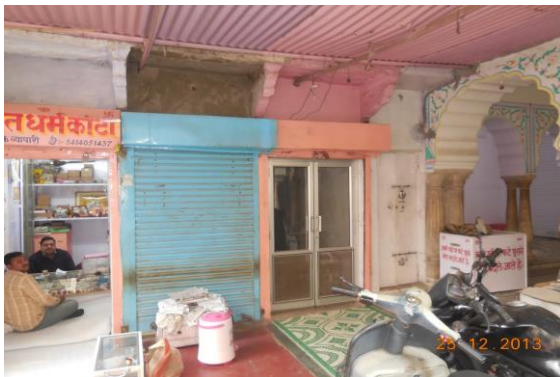
Photo 56
Office No.2 of Ground floor Locked

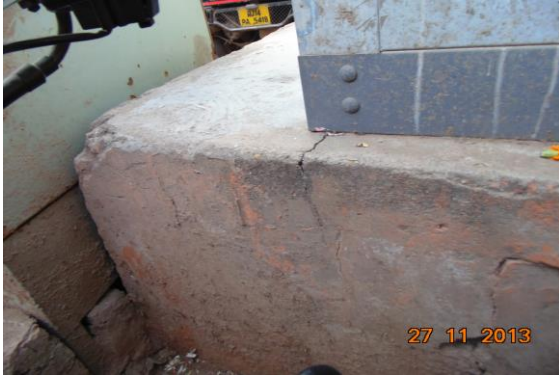
Photo 7

Plaster Crack on Platform of Transformer of Ground Floor

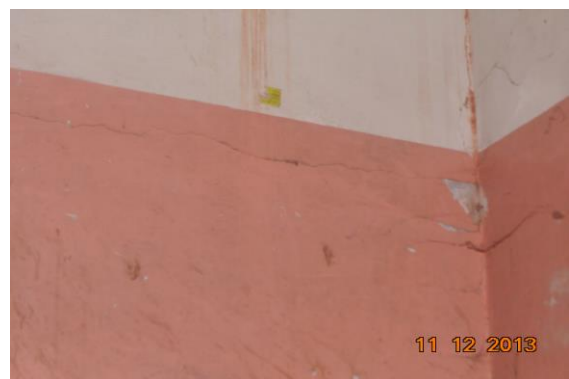
Photo 84
Horizontal Crack on Wall No. 1 of Staircase Area, First Floor
Approx. Width = 0.3mm, Approx. Length = 1.2m.
Distance from Wall No.4 = 0m, Height from Floor = 1.8m.

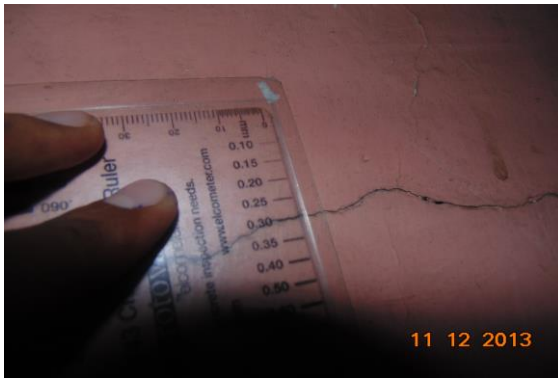
Photo 84A

Horizontal Crack on Wall No. 1 of Staircase Area, First Floor
Approx. Width = 0.3mm, Approx. Length = 1.2m.
Distance from Wall No.4 = 0m, Height from Floor = 1.8m.

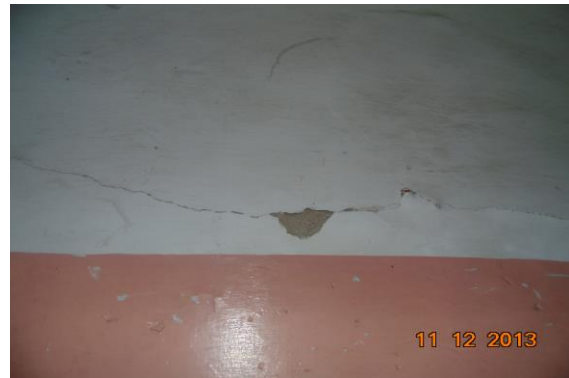
Photo 85

Horizontal Crack on Wall No. 4 of Staircase Area, First Floor
Approx. Width = 1.5mm, Approx. Length = 2.3m.
Distance from Wall No.1 = 0m, Height from Floor = 2m.

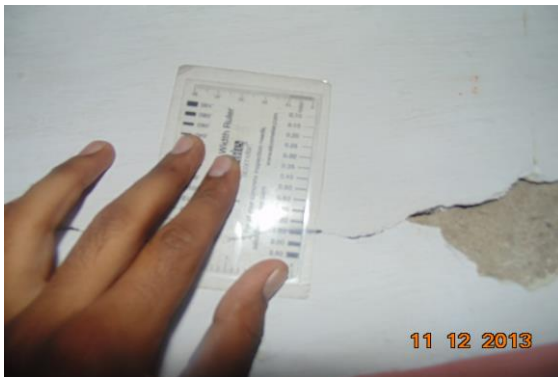
Photo 85A

Horizontal Crack on Wall No. 4 of Staircase Area, First Floor
Approx. Width = 1.5mm, Approx. Length = 2.3m.
Distance from Wall No.1 = 0m, Height from Floor = 2m.

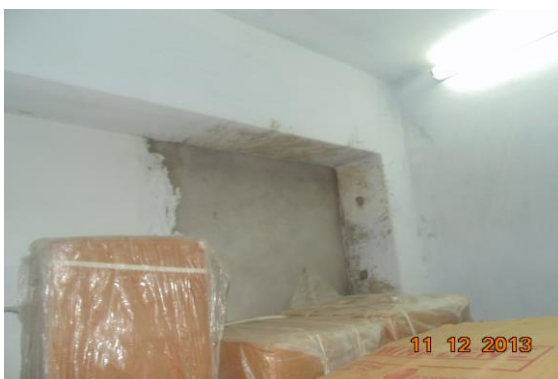
Photo 87

Peeling of Plaster on Wall No. 1 of Shop No.B-22 of Basement

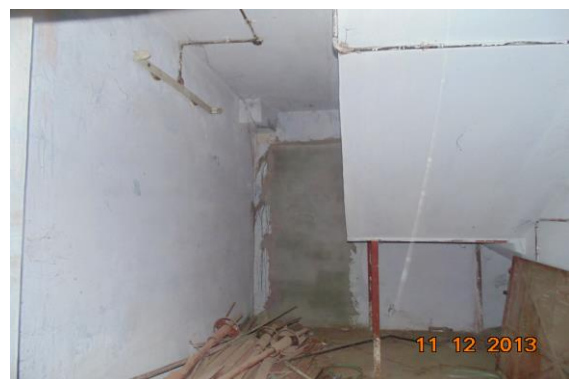
Photo 88

Peeling of Plaster on Wall No. 4 of Shop No.B-20 of Basement

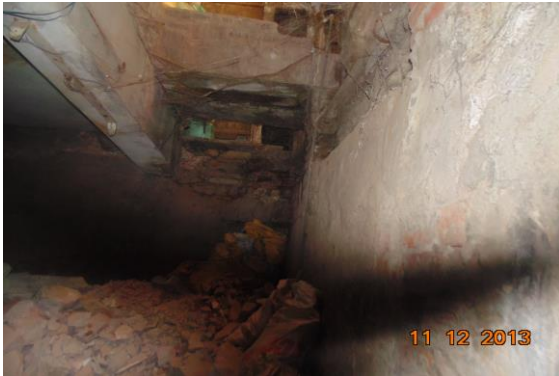
Photo 89

Damaged Portion on Wall No. 2 & 4 of Shop No. B-17 & 19 of Basement

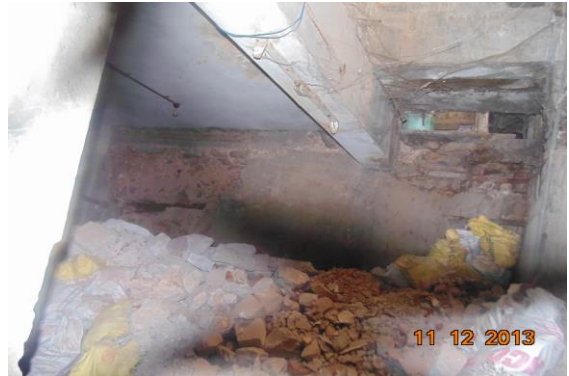
Photo 90

Damaged Portion on Wall No. 2 & 4 of Shop No. B-17 & 19 of Basement

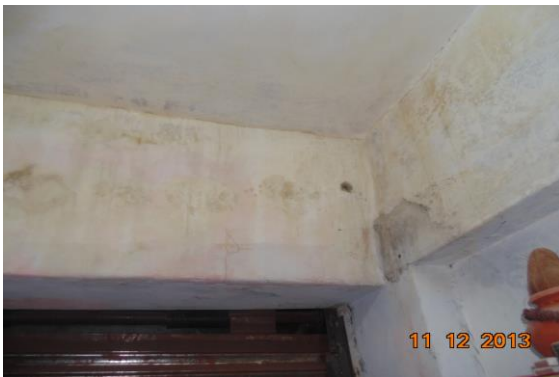
Photo 91

Dampness/Seepage on Wall No. 2 & 4 of Part 2 of Shop No. B-12 of Basement

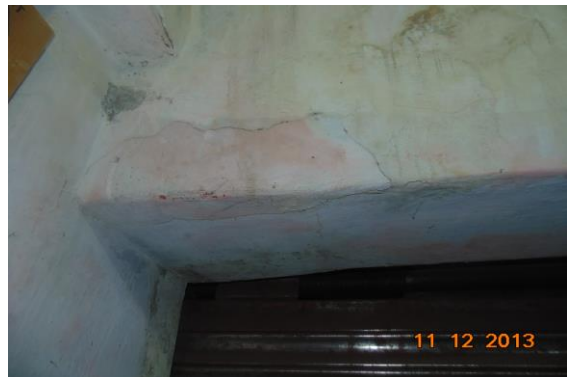
Photo 92

Peeling of Plaster on Wall No. 4 of Part 2 of Shop No. B-12 of Basement

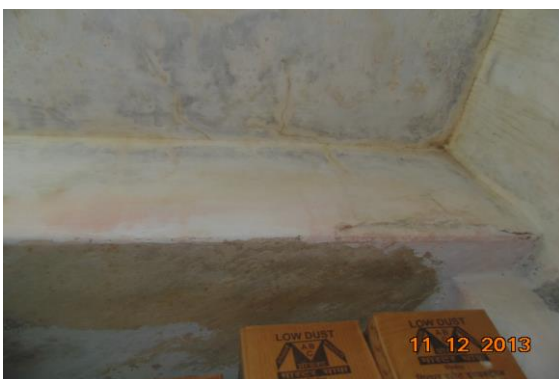
Photo 93

Dampness/Seepage on Wall No. 1 & 4 of Part 2 of Shop No. B-12 of Basement

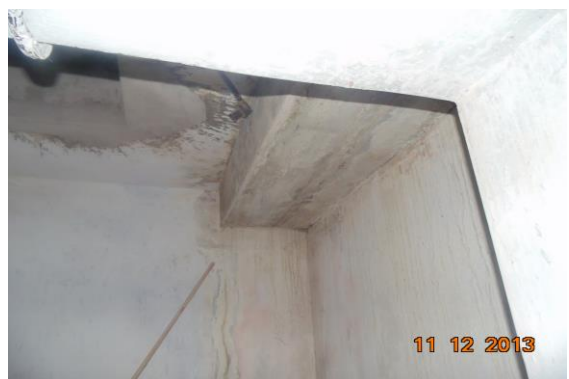
Photo 94

Dampness/Seepage on Wall No. 1 of Part 2 of Shop No. B-12 of Basement

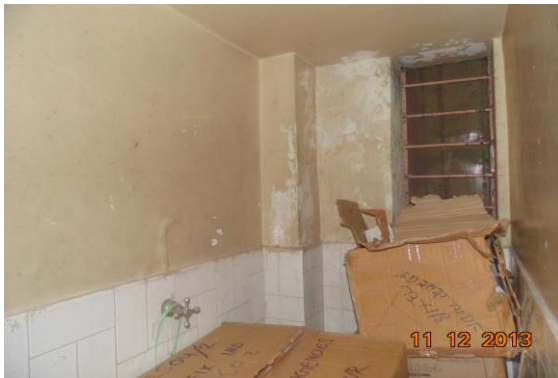
Photo 95

Peeling of Plaster on Wall No. 2 of Toilet No. 1 of Ground Floor

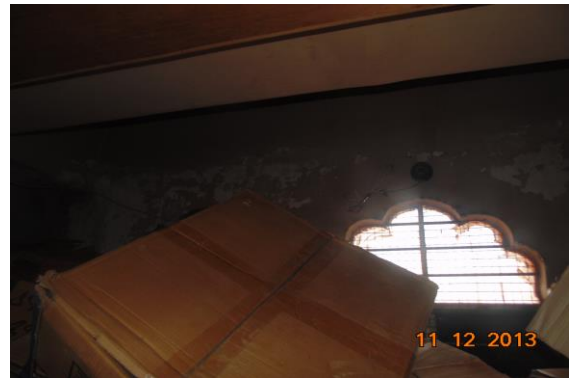
Photo 96

Peeling of Plaster on Wall No. 4 of Shop No.148 of First Floor

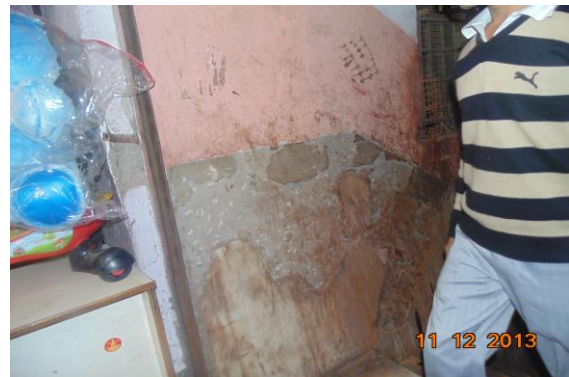
Photo 98

Damaged Portion on Outer Wall of Shop No.118 A of First Floor

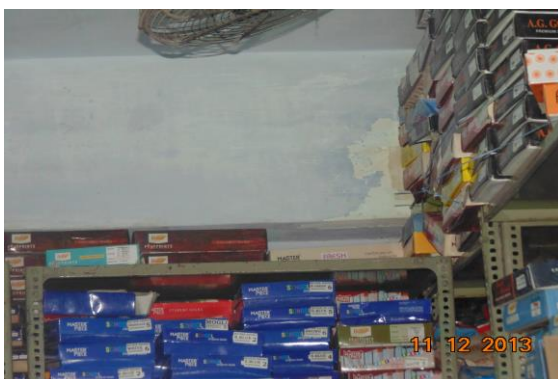
Photo 99

Peeling of Plaster on Wall No. 4 of Shop No.120 of First Floor
