Pre Building Condition Survey Report

Name and Address of Structure :	Badi Chopar Station Area
---------------------------------	--------------------------

Name of the Project	Contract JMRC-UG1B “Design and Construction of Tunnel between Chandpole and Badi Chouper and reverse line by Shield TBM, Underground Metro Stations at Choti Chouper and Badi Chouper by Cut and Cover Methods on East West Corridor of Jaipur Metro Rail Corporation Limited .”	
Owner :

Pre - Condition Building Survey for Construction of Underground Stations from Chandpole to Bari Chouper and reversal line

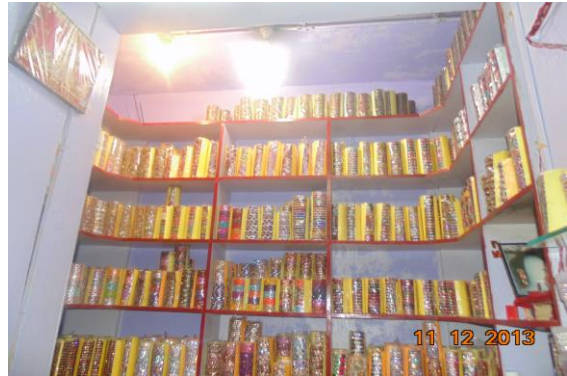
Photo 107

Wall No. 2 & 4 of Shop No.B-6A of Basement Covered With Wooden Work & Material

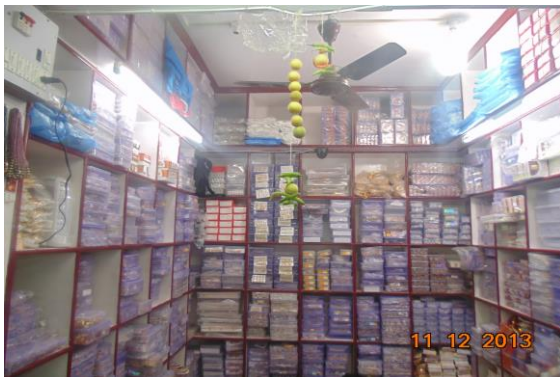
Photo 108

All Walls of Shop No.B-7A of Basement Covered With Wooden Work & Material

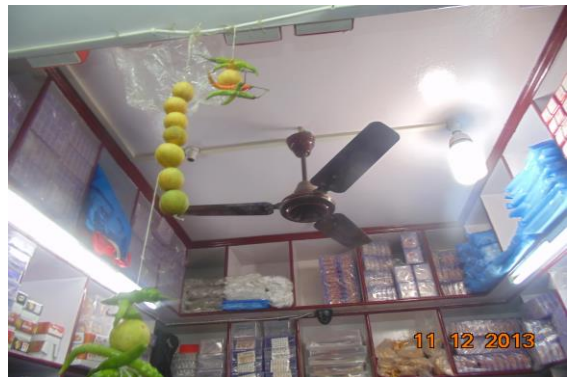
Photo 109

All Walls of Shop No.13 of Basement Covered With Wooden Work & Material

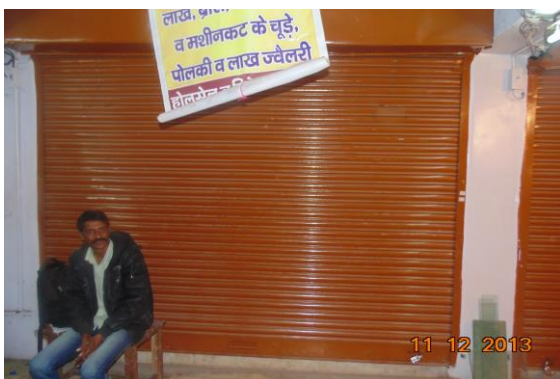
Photo 110

Roof of Shop No.13 of Basement Covered With Wooden Work

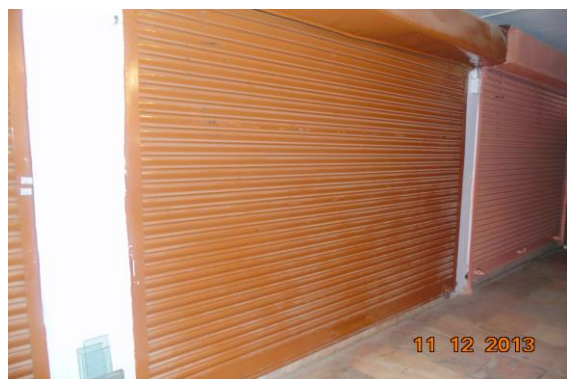
Photo 111

Shop B-14 of Basement Locked

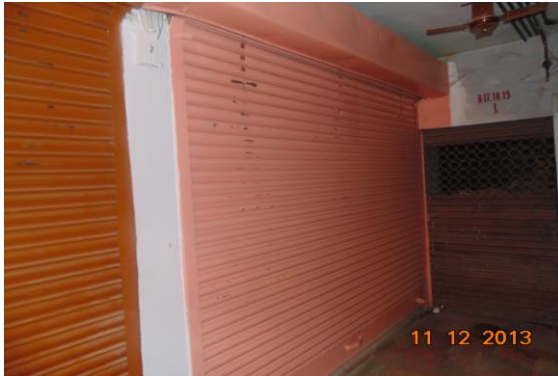
Photo 112

Shop B-15 of Basement Locked

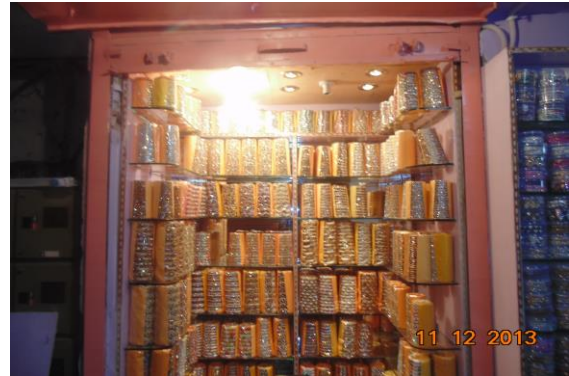
Photo 113
Shop B-16 of Basement Locked

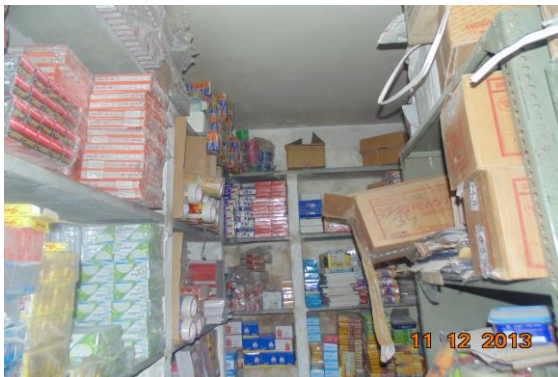
Photo 114
All Walls of Shop No.B-21 of Basement Covered With Material

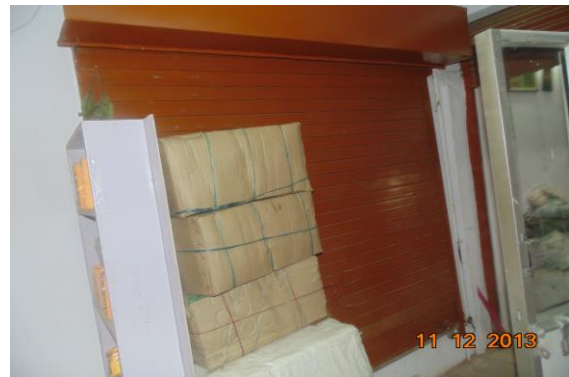
Photo 115
All Walls of Part 1 of Shop No.B-12 of Basement Covered With Material

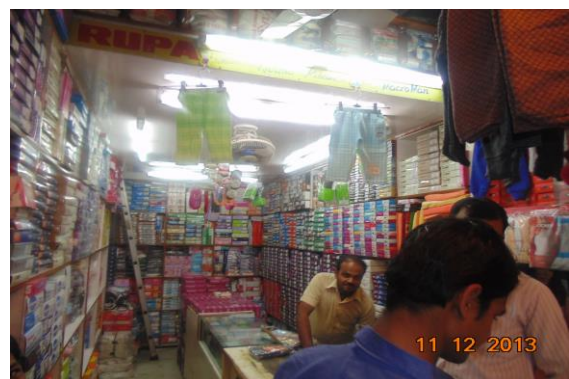
Photo 117
Wall No. 1 & 4 of Shop No.5 of Ground Floor Covered With Material & Wooden Racks

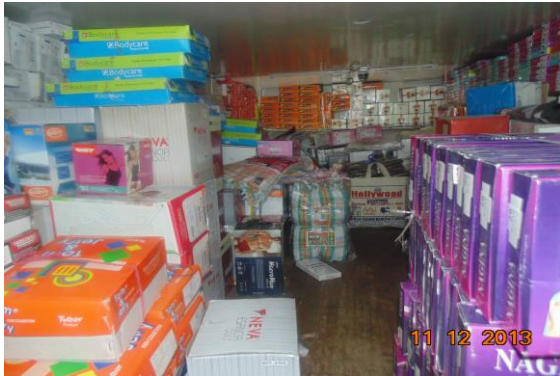
Photo 118
Wall No. 2 & 4 of Shop No.5 of Ground Floor Covered With Material & Wooden Racks

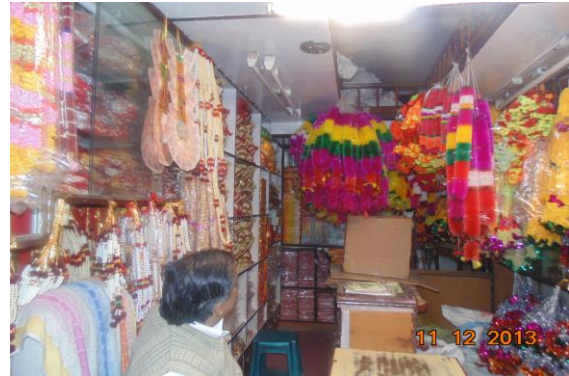
Photo 119
All Walls of Shop No.5 of Upper Ground Floor

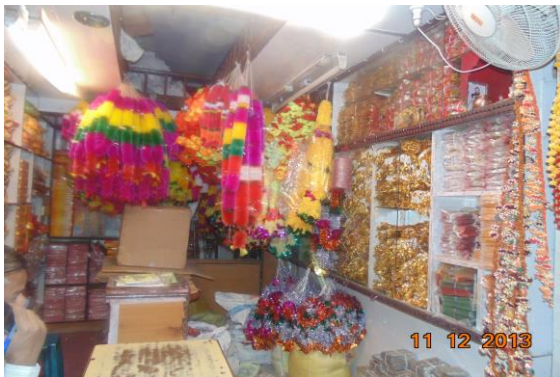
Photo 120
Wall No. 1 & 4 of Shop No.6 of Ground Floor Covered With Material & Wooden Racks

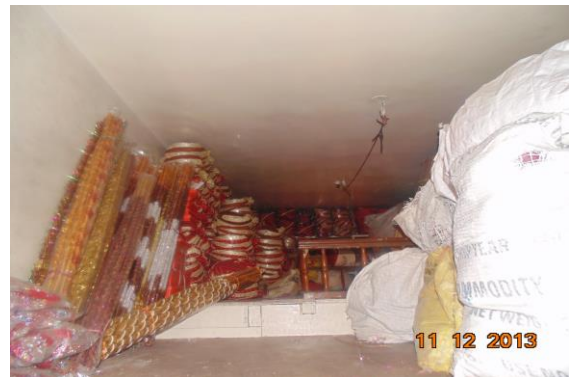
Photo 121
Wall No. 2 & 4 of Shop No.6 of Ground Floor Covered With Material & Wooden Racks

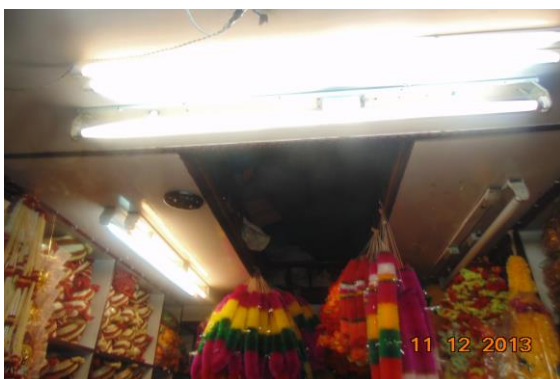
Photo 122
All Walls of Shop No.6 of Upper Ground Floor Covered With Material & Wooden Racks

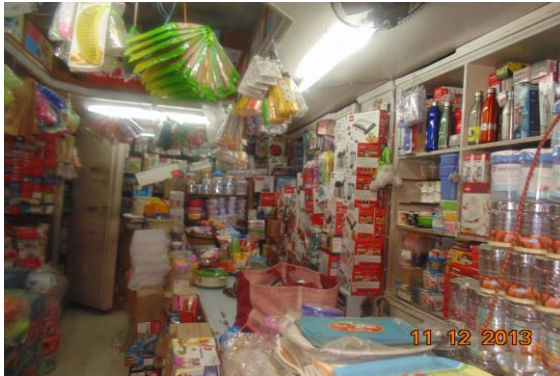
Photo 124
Wall No. 1 & 4 of Shop No.4 of Ground Floor Covered With Material & Wooden Racks

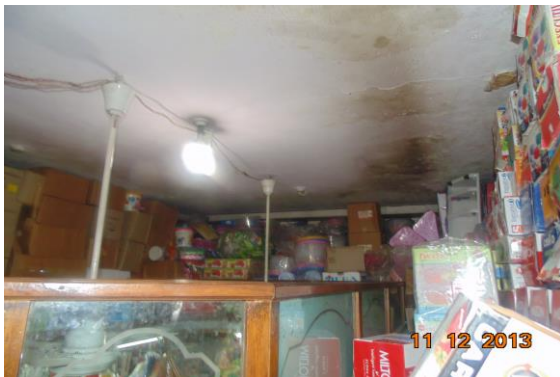
Photo 126

Roof of Shop No.4 of Ground Floor Covered With Wooden

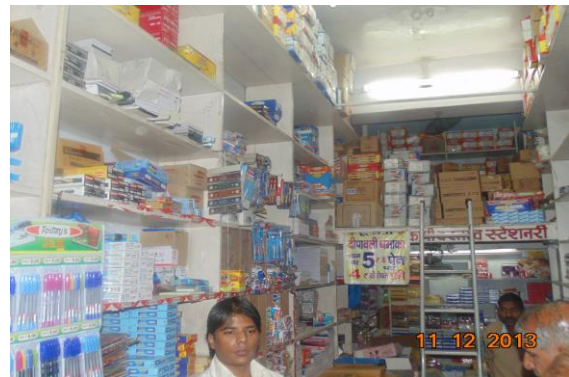
Photo 127

All Walls of Shop No.4 of Upper Ground Floor Covered With Material & Wooden Racks

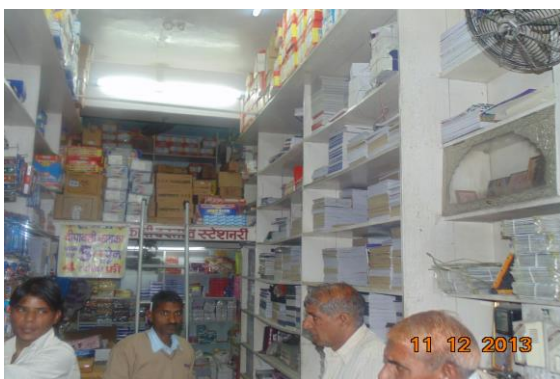
Photo 128

Wall No. 1 & 4 of Shop No.3 of Ground Floor Covered With Material & Wooden Racks

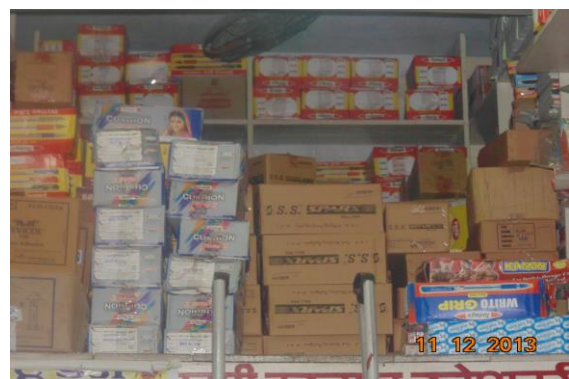
Photo 129

Wall No. 2 & 4 of Shop No.3 of Ground Floor Covered With Material & Wooden Racks

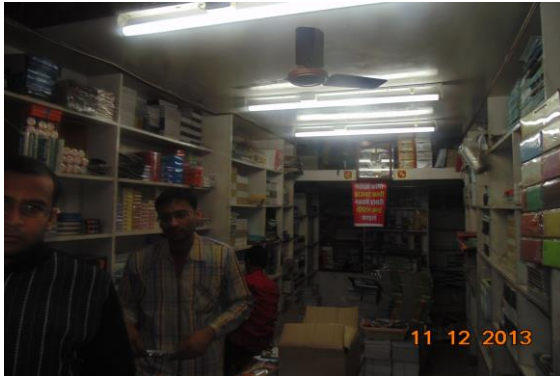
Photo 130

All Walls of Shop No.3 of Ground Floor Covered With Material & Wooden Racks

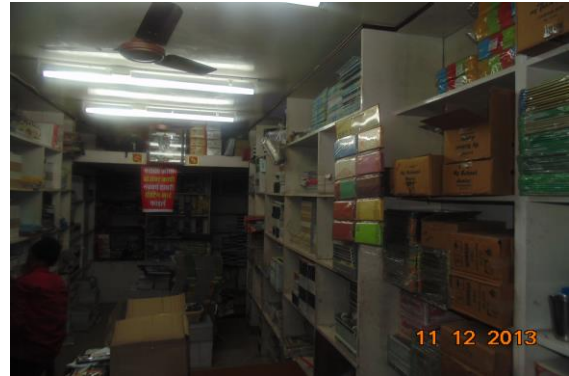
Photo 131

Wall No. 1 & 4 of Shop No.2 of Ground Floor Covered With Material & Wooden Racks

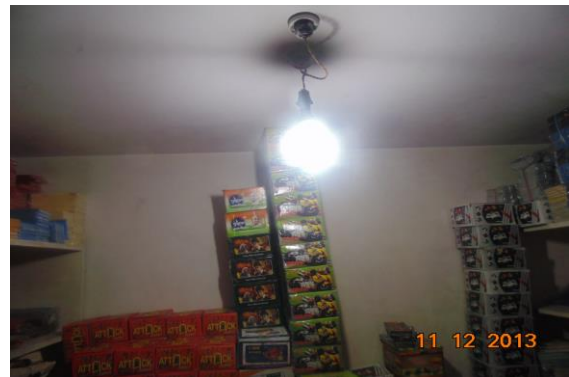
Photo 133

Roof of Shop No.2 of Ground Floor Covered With Wooden Work

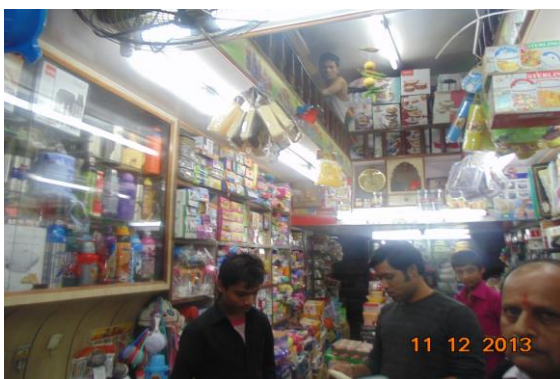
Photo 134

All Walls of Shop No.2 of Upper Ground Floor Covered With Material & Wooden Racks

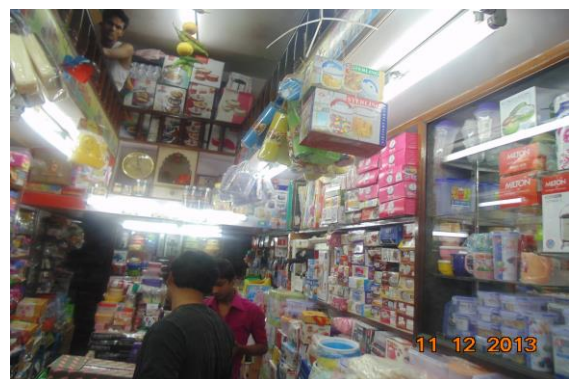
Photo 135

Wall No. 1 & 4 of Shop No.1 of Ground Floor Covered With Material & Wooden Racks

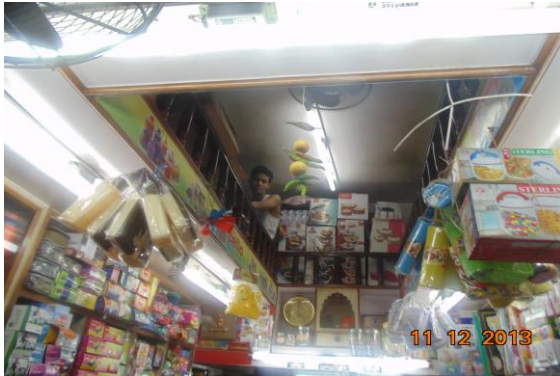
Photo 136

Wall No. 2 & 4 of Shop No.1 of Ground Floor Covered With Material & Wooden Racks

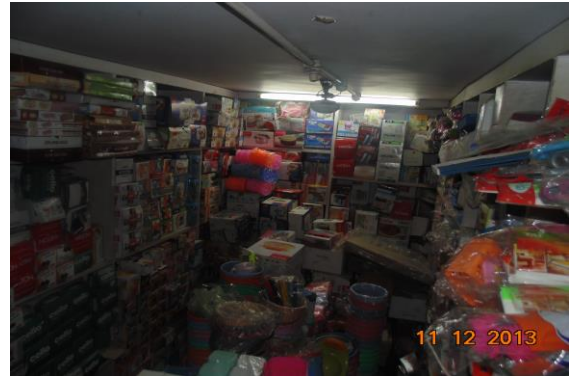
Photo 137

Roof of Shop No.1 of Ground Floor Covered With Wooden Work

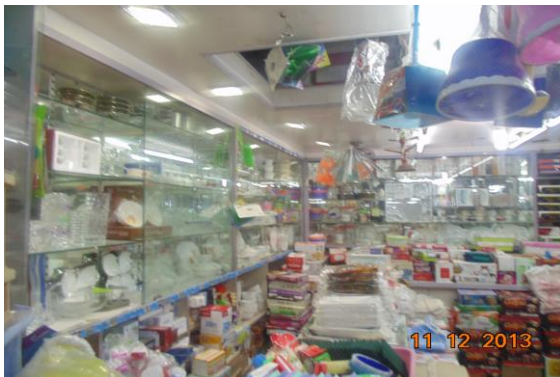
Photo 138

All Walls of Shop No.1 of Basement Covered With Material & Wooden Racks

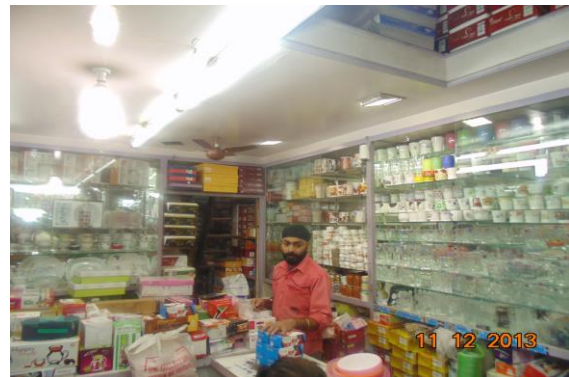
Photo 139

Wall No. 1 & 4 of Shop No.14 & 15 of Ground Floor Covered With Material & Wooden Racks

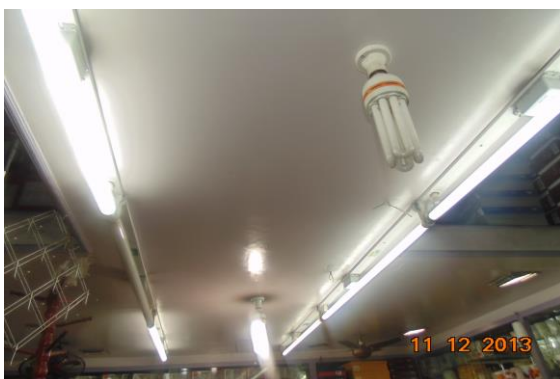
Photo 140

Wall No. 2 & 4 of Shop No.14 & 15 of Ground Floor Covered With Material & Wooden Racks

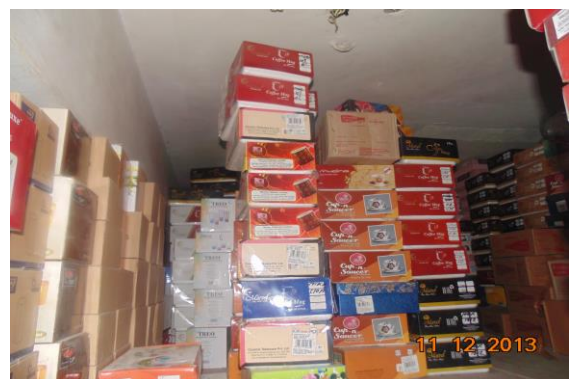
Photo 141

Roof of Shop No.14 & 15 of Ground Floor Covered With Wooden Work

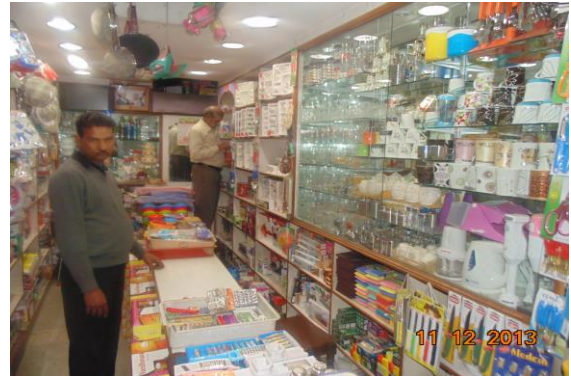
Photo 143

Wall No. 1 & 4 of Shop No.13 of Ground Floor Covered With Material & Wooden Racks

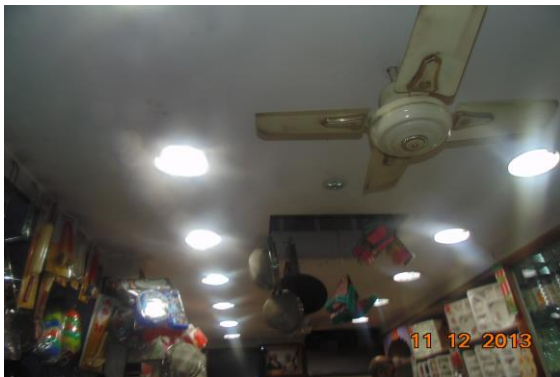
Photo 144

Wall No. 2 & 4 of Shop No.13 of Ground Floor Covered With Material & Wooden Racks

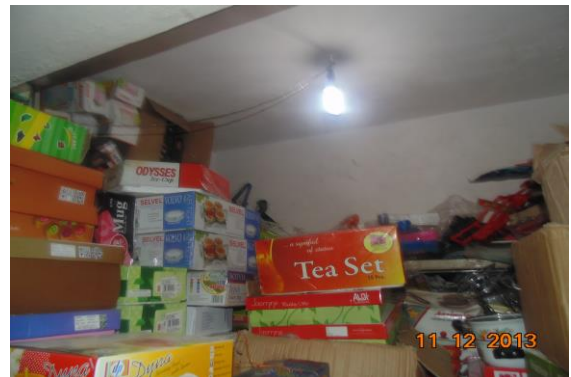
Photo 145

Roof of Shop No.13 of Ground Floor Covered With Wooden Work

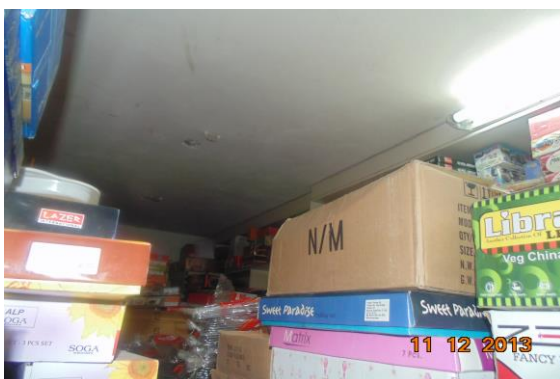
Photo 146

All Walls of Shop No.13 of Upper Ground Floor Covered With Material & Wooden Racks

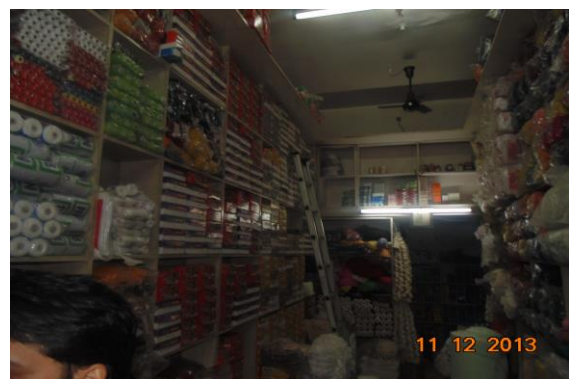
Photo 147

All Walls of Shop No.13 of Upper Ground Floor Covered With Material & Wooden Racks

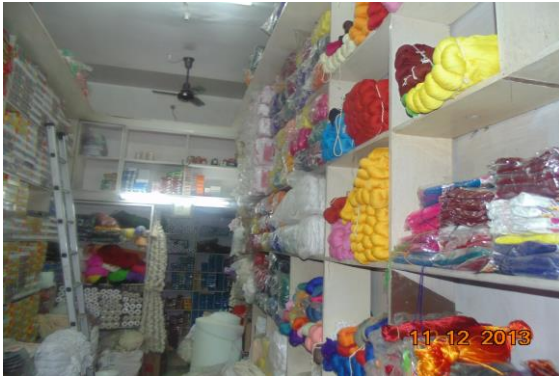
Photo 148

Wall No. 1 & 4 of Shop No.12 of Ground Floor Covered With Material & Wooden Racks

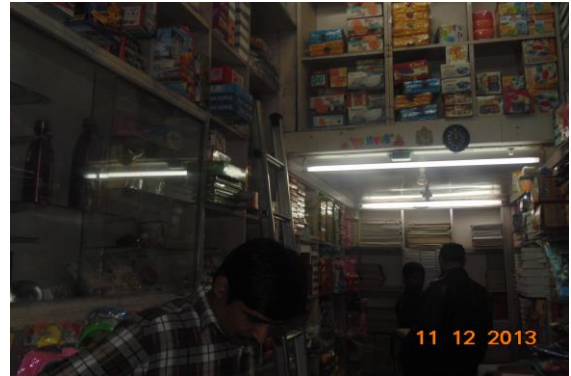
Photo 149

Wall No. 2 & 4 of Shop No.12 of Ground Floor Covered With Material & Wooden Racks

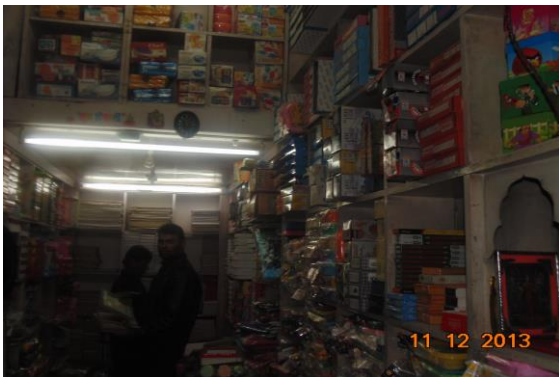
Photo 150

Wall No. 1 & 4 of Shop No.11 of Ground Floor Covered With Material & Wooden Racks

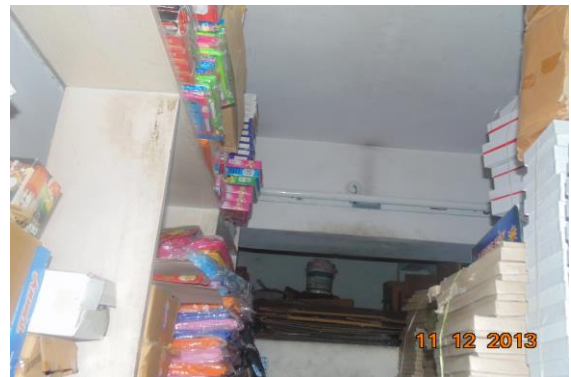
Photo 151

Wall No. 2 & 4 of Shop No.11 of Ground Floor Covered With Material & Wooden Racks

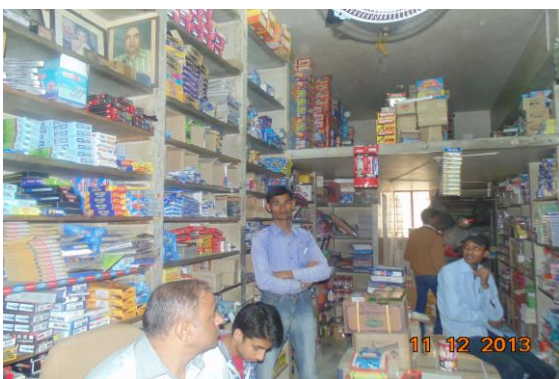
Photo 152

All Walls of Shop No.11 of Upper Ground Floor Covered With Material & Wooden Racks

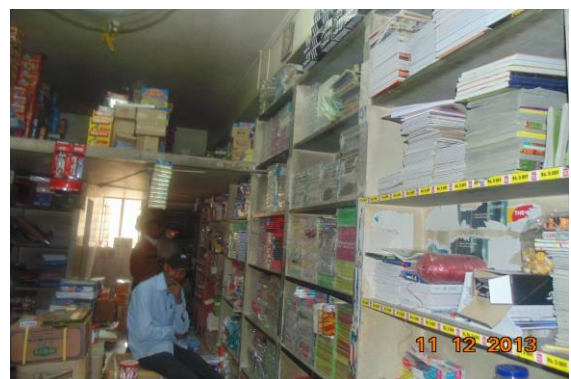
Photo 153

Wall No. 1 of Shop No.10 of Ground Floor Covered With Material & Wooden Racks

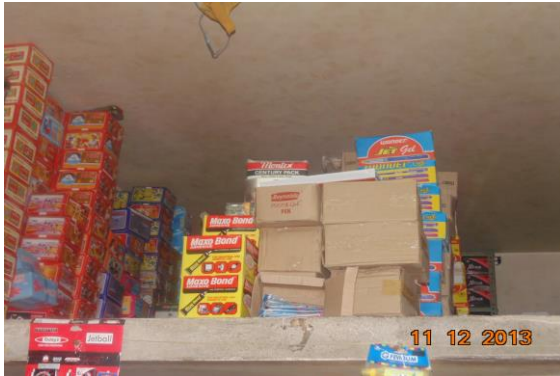
Photo 154

Wall No. 2 of Shop No.10 of Ground Floor Covered With Material & Wooden Racks

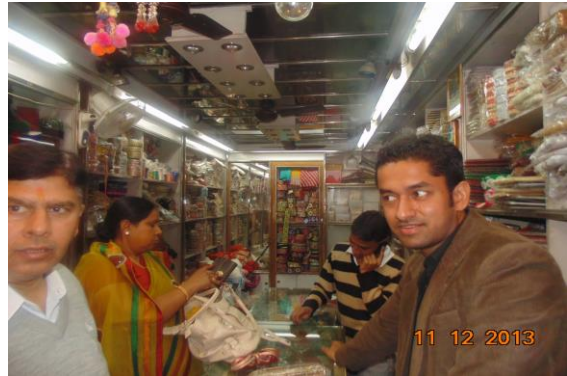
Photo 155

All Walls of Shop No.10 of Upper Ground Floor Covered With Material & Wooden Racks

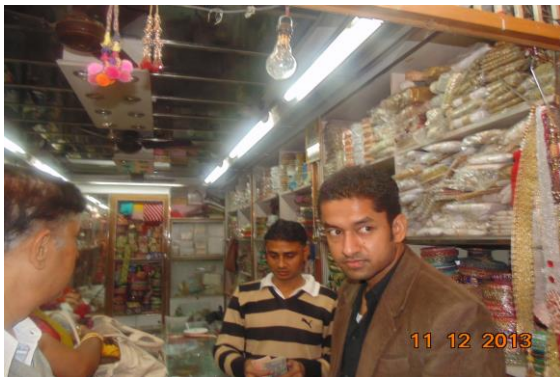
Photo 156

Wall No. 1 & 4 of Shop No.9 of Ground Floor Covered With Material & Wooden Racks

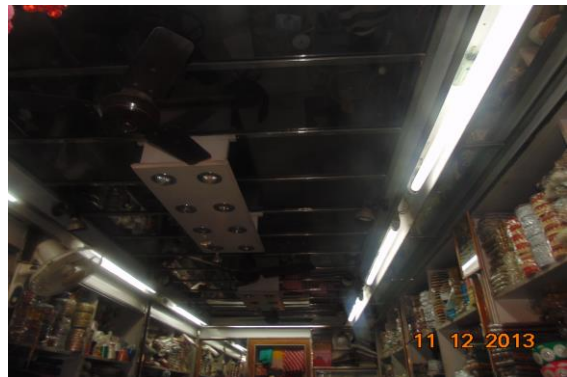
Photo 157

Wall No. 2 & 4 of Shop No.9 of Ground Floor Covered With Material & Wooden Racks

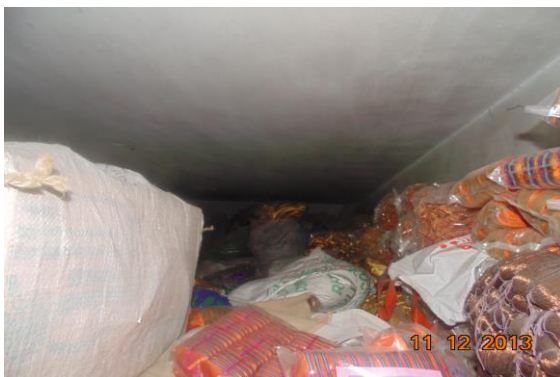
Photo 158

Roof of Shop No.9 of Ground Floor Covered With Wooden Work

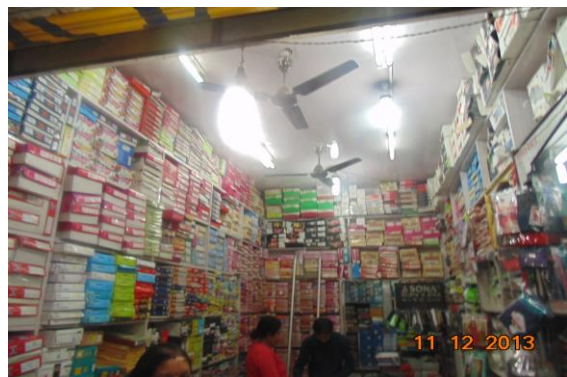
Photo 159

All Walls of Shop No.9 of Upper Ground Floor Covered With Material & Wooden Racks

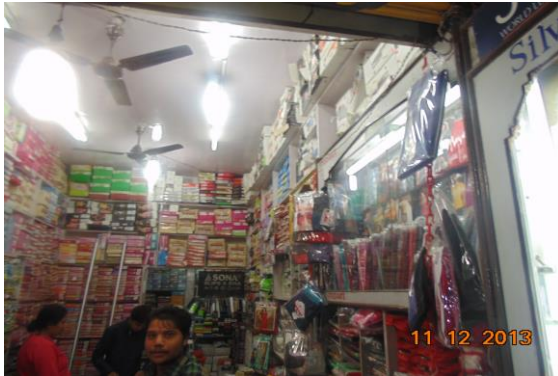
Photo 160

Wall No. 1 & 4 of Shop No.8 of Shri Shiv Store Covered With Material & Wooden Racks

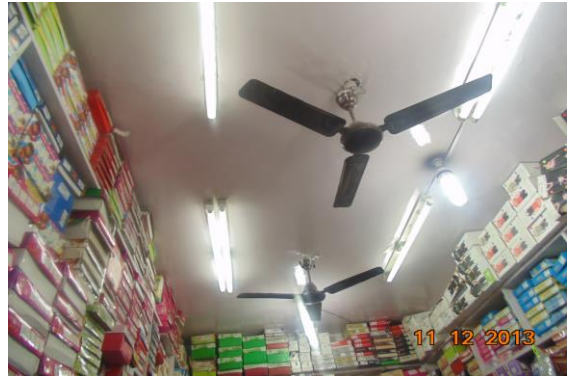
Photo 161

Wall No. 2 & 4 of Shop No.8 of Shri Shiv Store Covered With Material & Wooden Racks

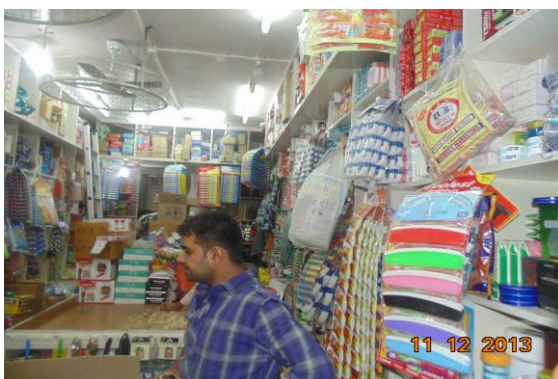
Photo 164

Wall No. 1 & 4 of Shop No.154 of First Floor Covered With Material & Wooden Racks

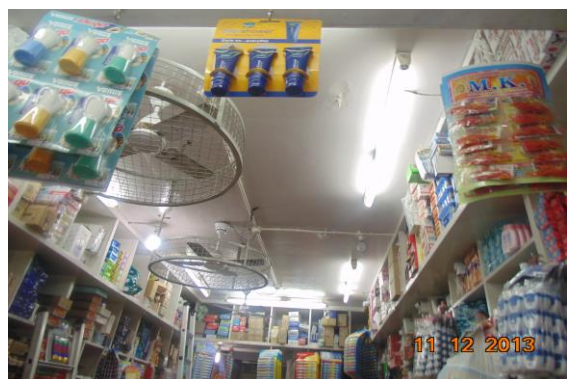
Photo 165

Wall No. 2 & 4 of Shop No.154 of First Floor Covered With Material & Wooden Racks

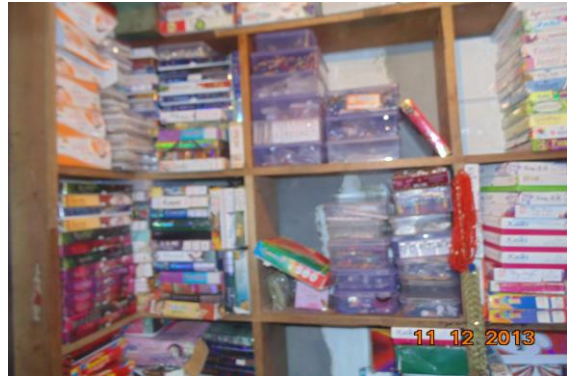
Photo 167

Wall No. 2 & 4 of Shop No.171 of First Floor Covered With Material & Wooden Racks

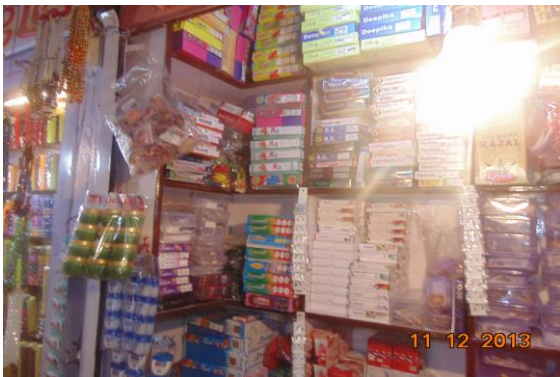
Photo 168

Wall No. 1 & 4 of Shop No.171 of First Floor Covered With Material & Wooden Racks

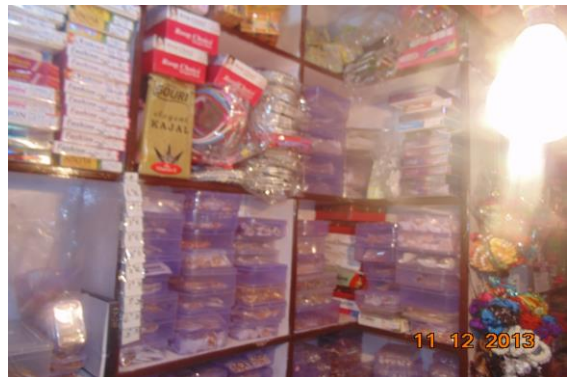
Photo 169

Wall No. 1 & 4 of Shop No.172 A of First Floor Covered With Material & Wooden Racks

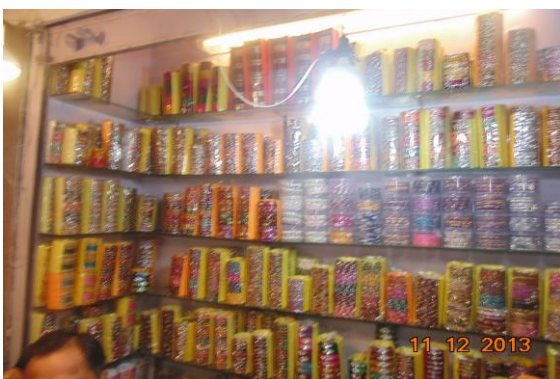
Photo 170

Wall No. 2 & 4 of Shop No.172 A of First Floor Covered With Material & Wooden Racks

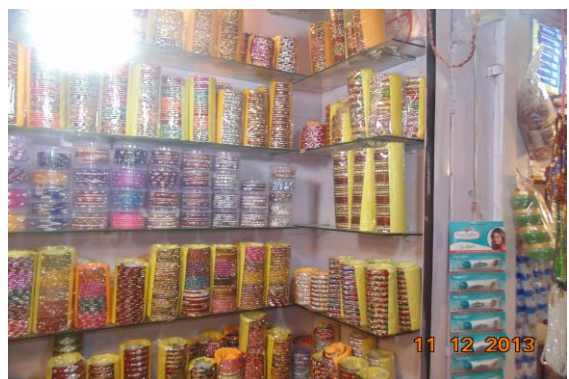
Photo 171

Wall No. 1 & 4 of Shop No.173 of First Floor Covered With Material & Wooden Racks

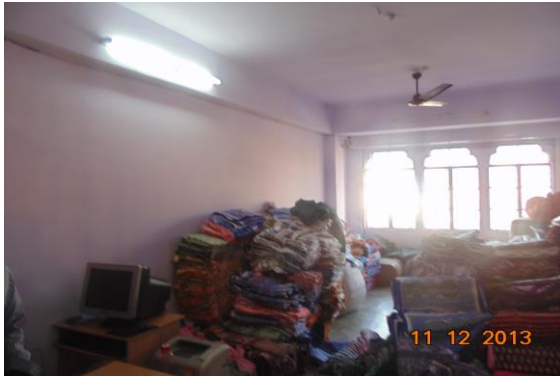
Photo 172

Wall No. 2 & 4 of Shop No.173 of First Floor Covered With Material & Wooden Racks

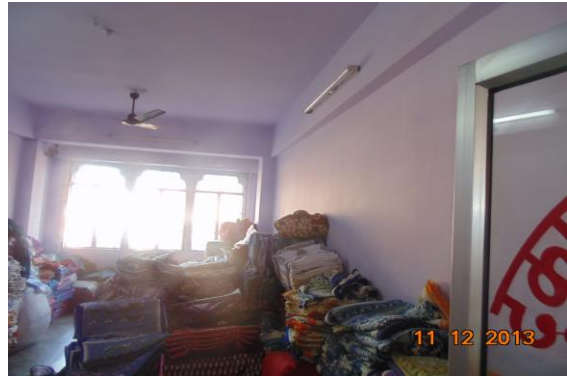
Photo 173

Wall No. 1 & 4 of Shop No.153 of First Floor Covered With Material & Wooden Racks

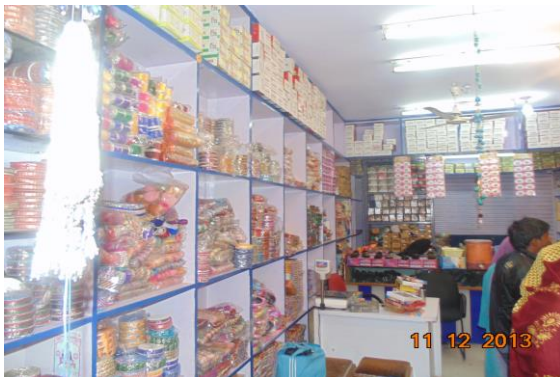
Photo 174

Wall No. 2 & 4 of Shop No.153 of First Floor Covered With Material & Wooden Racks

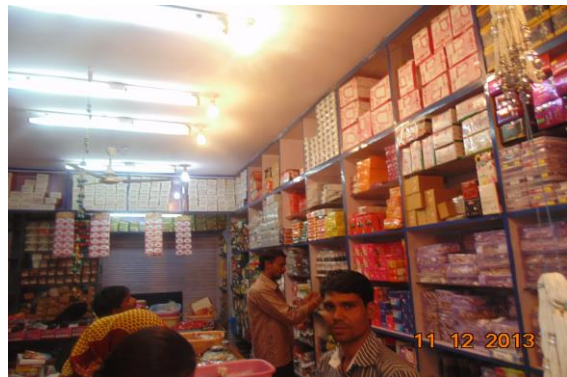
Photo 175

Wall No. 1 & 4 of Shop No.152 of First Floor Covered With Material & Wooden Racks

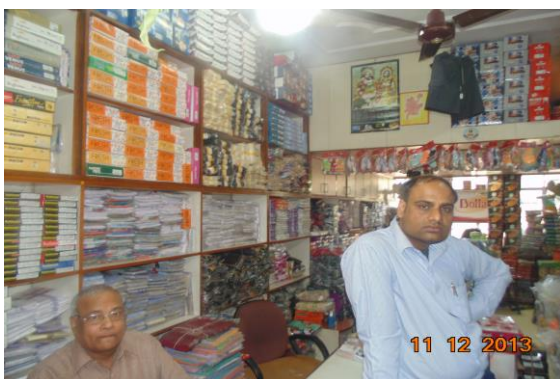
Photo 176

Wall No. 2 & 4 of Shop No.152 of First Floor Covered With Material & Wooden Racks

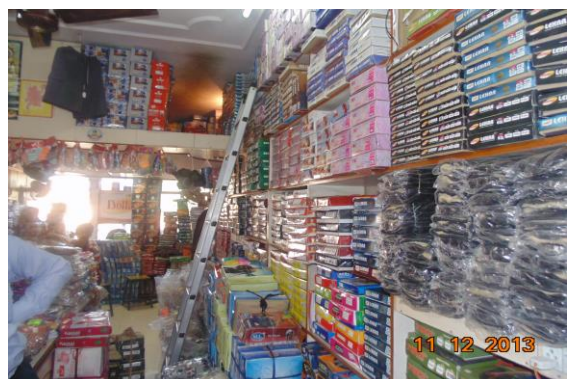
Photo 177

Wall No. 1 of Shop No.151 of First Floor Covered With Material & Wooden Racks

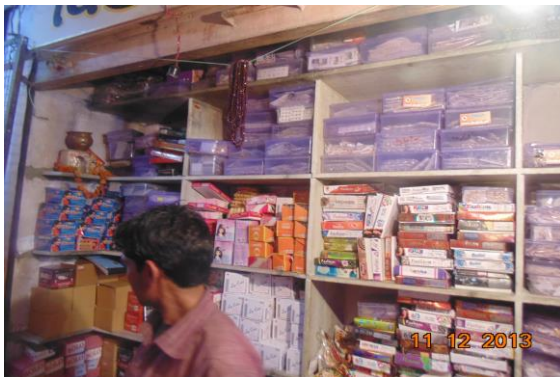
Photo 180

All Walls of Shop No.175 of First Floor Covered With Wooden Work

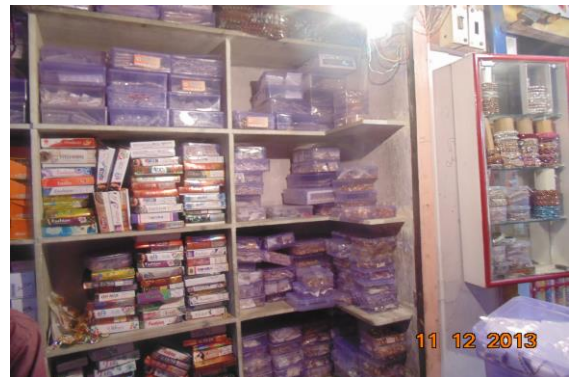
Photo 181

All Walls of Shop No.176 of First Floor Covered With Wooden Work

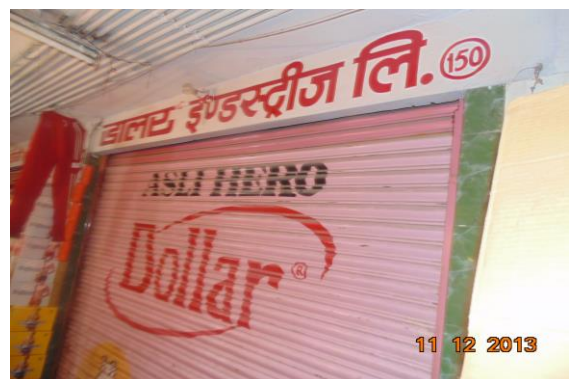
Photo 183

Shop No.150 of First Floor Locked

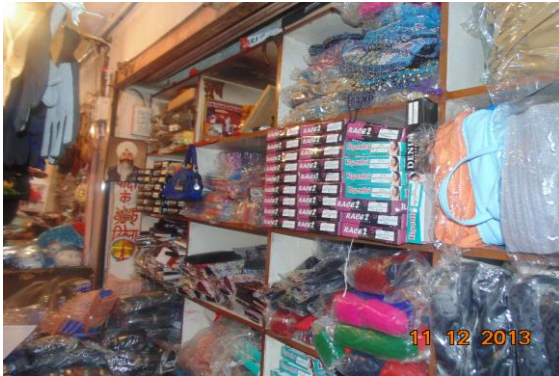
Photo 184

Shop No.150 of First Floor Locked

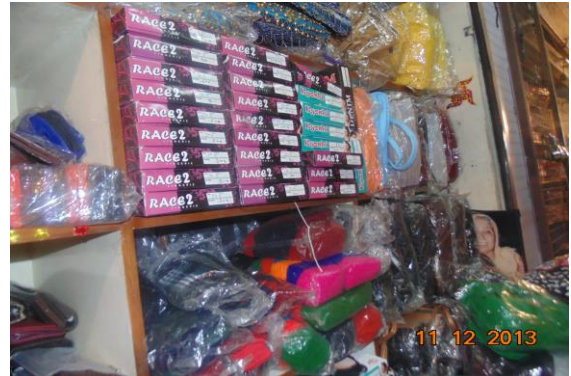
Photo 185

Wall No. 1 & 4 of Shop No.177 of First Floor Covered With Material & Wooden Racks

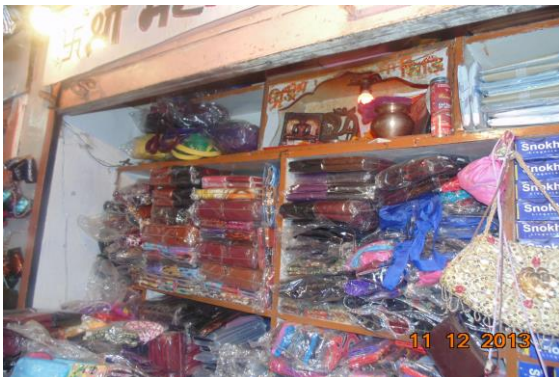
Photo 186

Wall No. 2 & 4 of Shop No.177 of First Floor Covered With Material & Wooden Racks

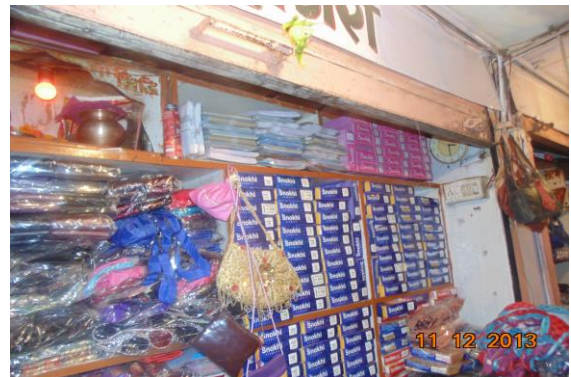
Photo 187

Wall No. 1 & 4 of Shop No.178 of First Floor Covered With Material & Wooden Racks

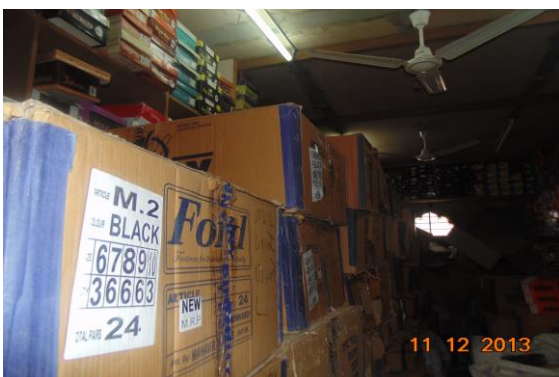
Photo 188

Wall No. 2 & 4 of Shop No.178 of First Floor Covered With Material & Wooden Racks

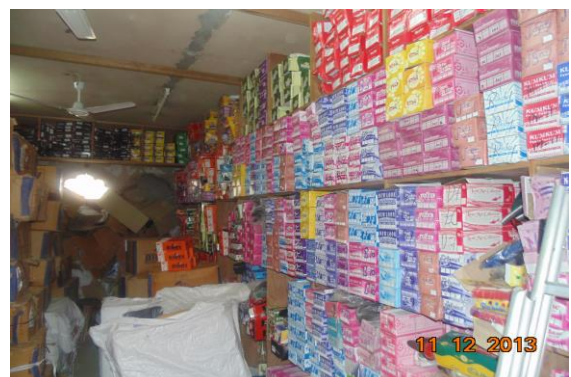
Photo 189

Wall No. 1 of Shop No.148 of First Floor Covered With Material & Wooden Racks

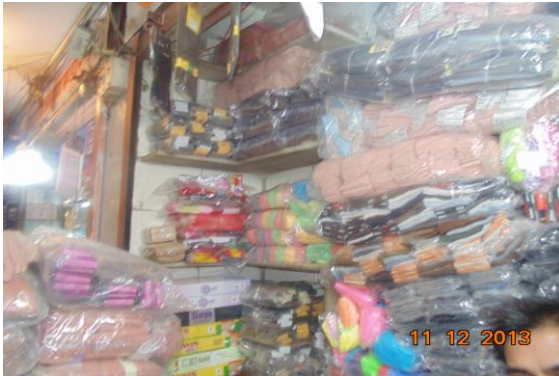
Photo 190

Wall No. 2 of Shop No.148 of First Floor Covered With Material & Wooden Racks

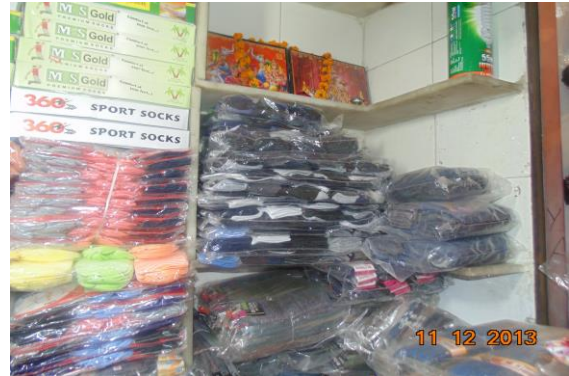
Photo 191

Wall No. 1 & 4 of Shop No.179 of First Floor Covered With Material & Wooden Racks

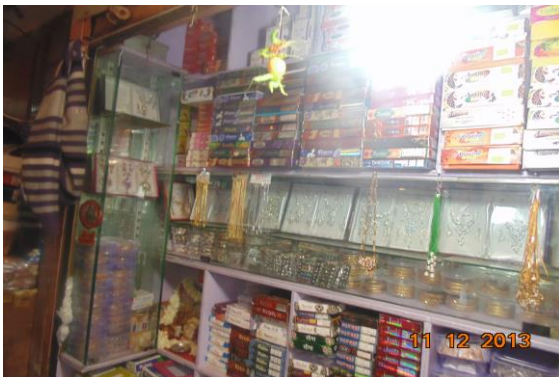
Photo 192

Wall No. 2 & 4 of Shop No.179 of First Floor Covered With Material & Wooden Racks

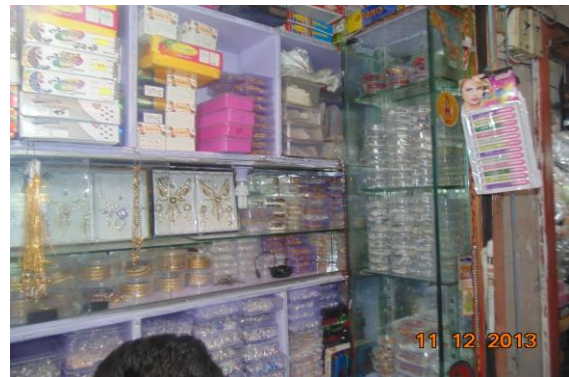
Photo 193

Wall No. 1 & 4 of Shop No.180 of First Floor Covered With Material & Wooden Racks

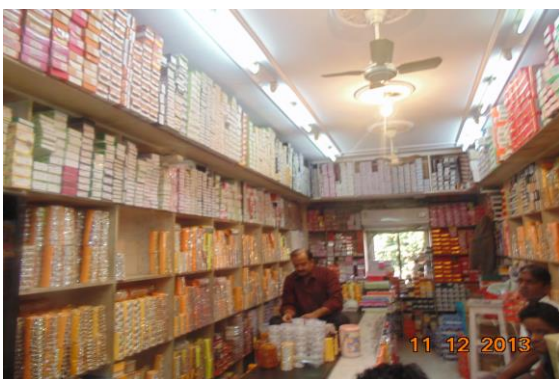
Photo 194

Wall No. 2 & 4 of Shop No.180 of First Floor Covered With Material & Wooden Racks

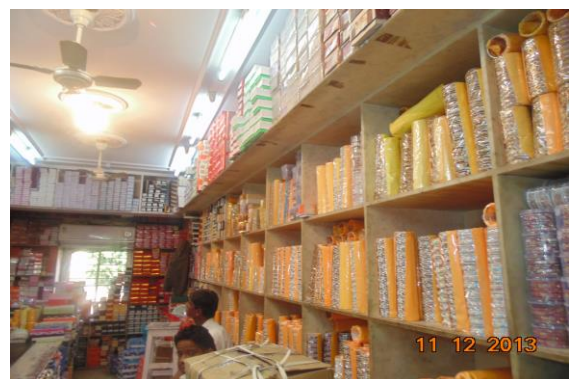
Photo 195

Wall No. 1 of Shop No.147 of First Floor Covered With Material & Wooden Racks

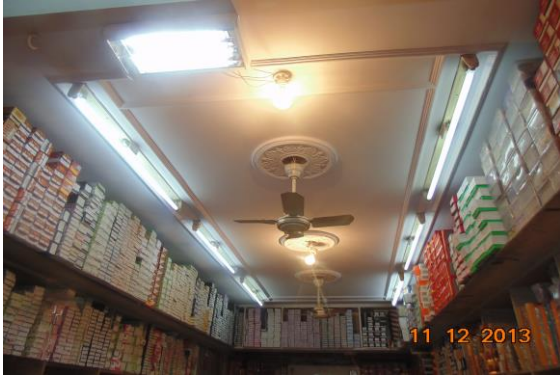
Photo 196

Wall No. 2 of Shop No.147 of First Floor Covered With Material & Wooden Racks

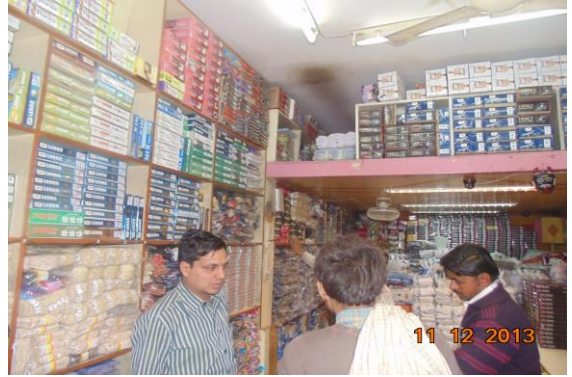
Photo 197

Roof of Shop No.147 of First Floor Covered With Falls Ceiling

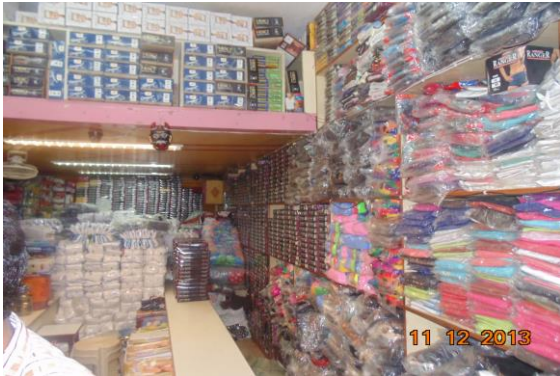
Photo 198

Wall No. 1 & 4 of Shop No.146 of First Floor Covered With Material & Wooden Racks

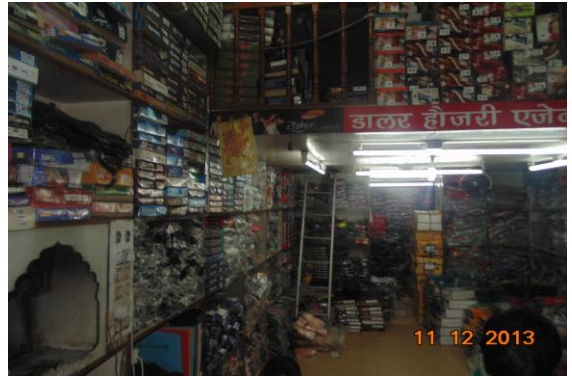
Photo 199

Wall No. 2 & 4 of Shop No.146 of First Floor Covered With Material & Wooden Racks

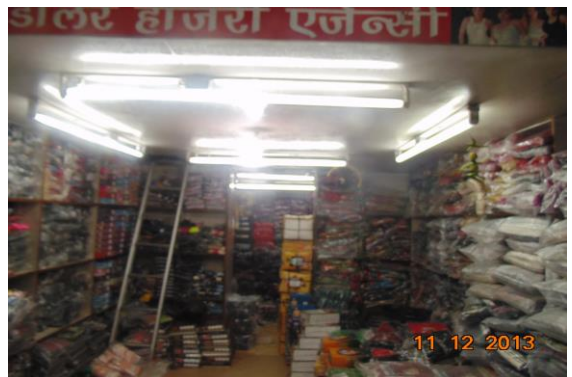
Photo 201

Wall No. 2 of Shop No.145 of First Floor Covered With Material & Wooden Racks

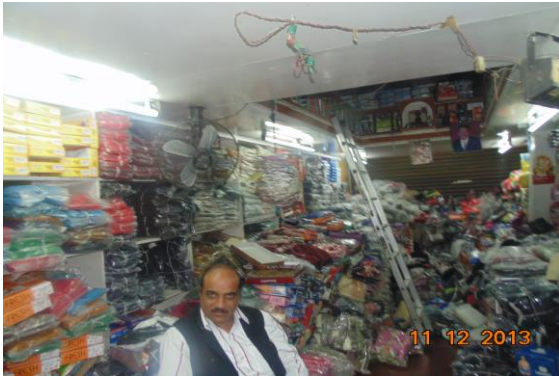
Photo 202

Wall No. 4 of Shop No.145 of First Floor Covered With Material & Wooden Racks

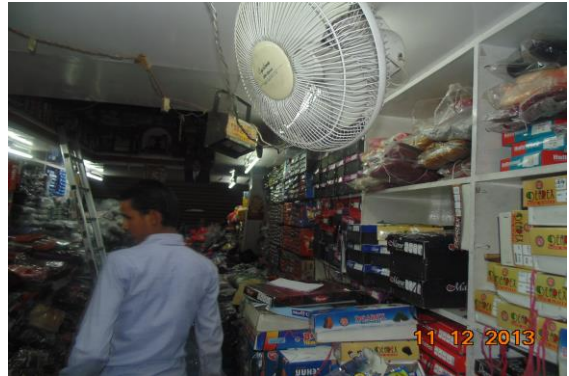
Photo 203

Wall No. 1 of Shop No.144 of First Floor Covered With Material & Wooden Racks

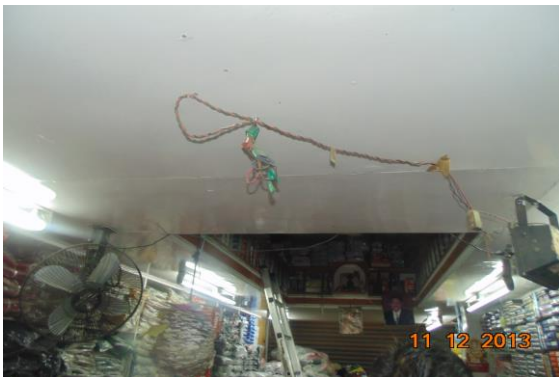
Photo 204

Wall No. 2 of Shop No.144 of First Floor Covered With Material & Wooden Racks

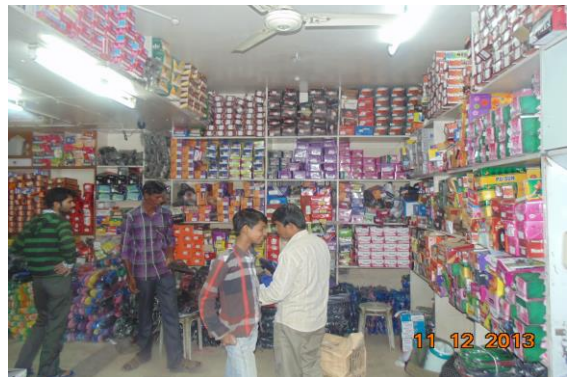
Photo 205

Roof of Shop No.144 of First Floor Covered With Falls Ceiling

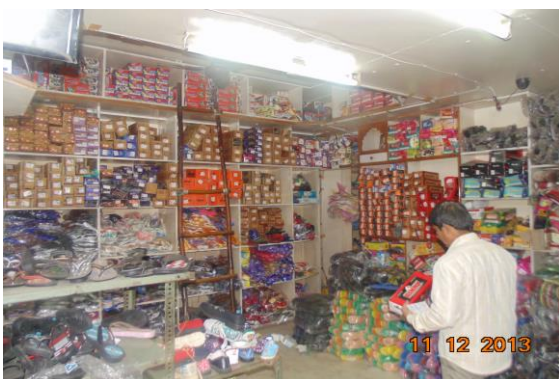
Photo 206

Wall No. 2 & 4 of Shop No.130 & 131 of First Floor Covered With Material & Wooden Racks

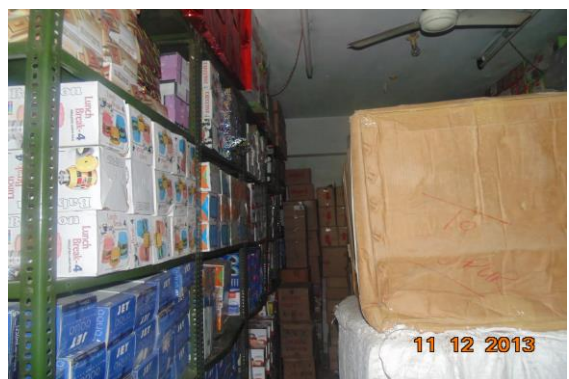
Photo 207

Wall No. 1 & 4 of Shop No.130 & 131 of First Floor Covered With Material & Wooden Racks

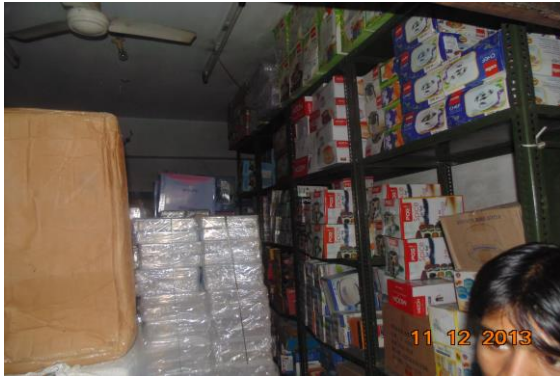
Photo 208

Wall No. 1 of Shop No.129 of First Floor Covered With Material & Wooden Racks

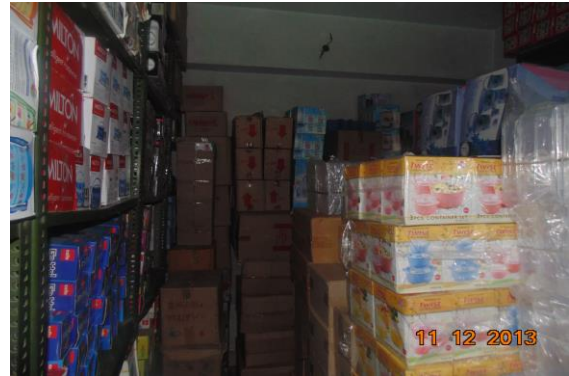
Photo 209
Wall No. 2 of Shop No.129 of First Floor Covered With Material & Wooden Racks

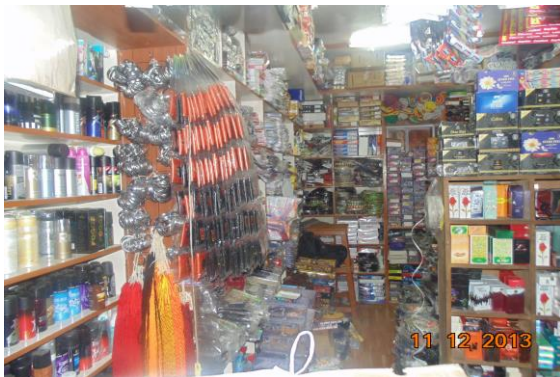
Photo 210
Wall No. 4 of Shop No.129 of First Floor Covered With Material & Wooden Racks

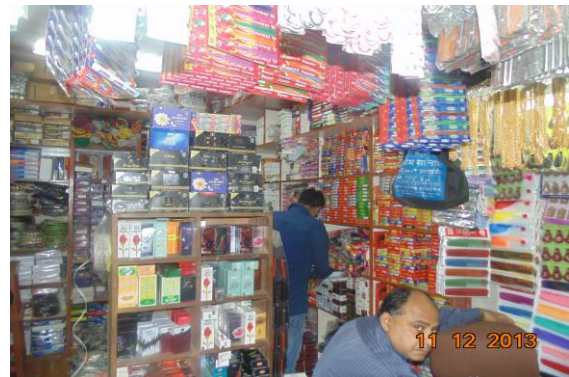
Photo 211
Wall No. 1 of Shop No.132 of First Floor Covered With Material & Wooden Racks

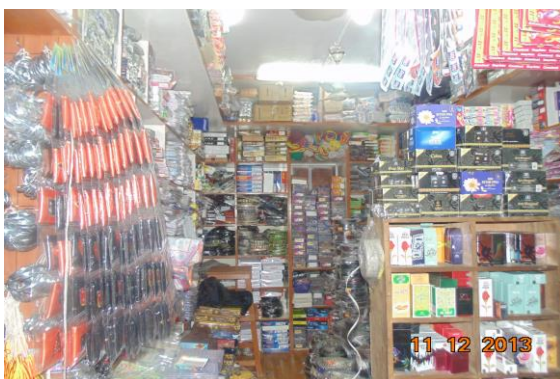
Photo 212
Wall No. 2 of Shop No.132 of First Floor Covered With Material & Wooden Racks

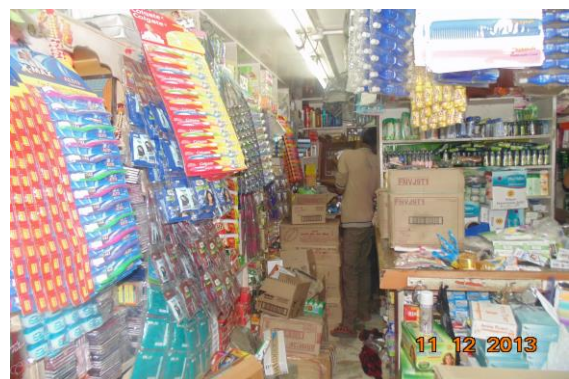
Photo 213
Wall No. 4 of Shop No.132 of First Floor Covered With Material & Wooden Racks

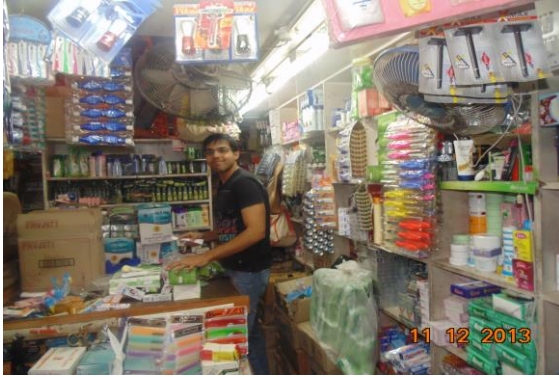
Photo 214
Wall No. 1 & 4 of Shop No.133 of First Floor Covered With Material & Wooden Racks

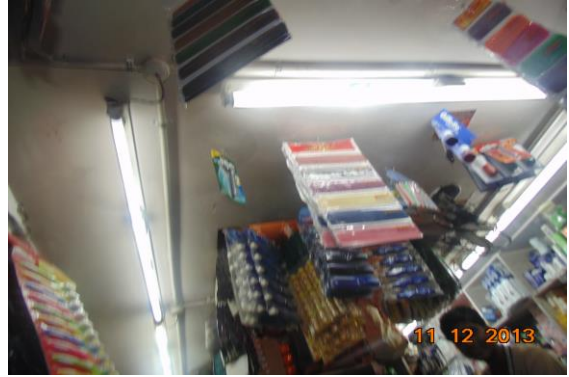
Photo 215

Wall No. 2 & 4 of Shop No.133 of First Floor Covered With Material & Wooden Racks
