Pre Building Condition Survey Report

Name and Address of Structure :	Badi Chopar Station Area
---------------------------------	--------------------------

Name of the Project	Contract JMRC-UG1B “Design and Construction of Tunnel between Chandpole and Badi Chouper and reverse line by Shield TBM, Underground Metro Stations at Choti Chouper and Badi Chouper by Cut and Cover Methods on East West Corridor of Jaipur Metro Rail Corporation Limited .”	
Owner :

Pre - Condition Building Survey for Construction of Underground Stations from Chandpole to Bari Chouper and reversal line

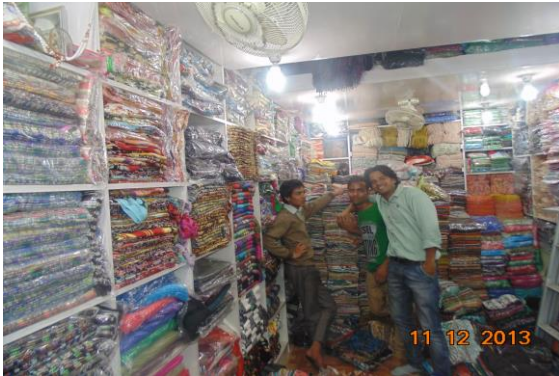
Photo 216

Roof of Shop No.133 of First Floor Covered With Wooden Work

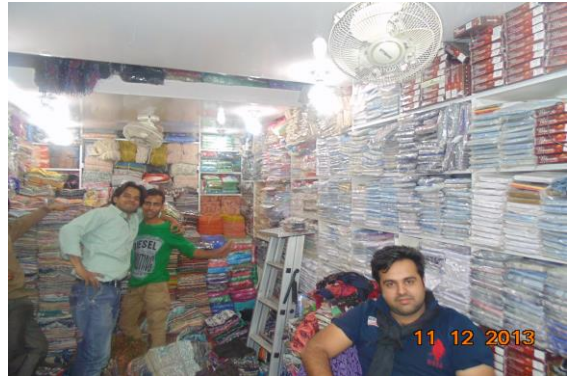
Photo 217

Wall No. 1 & 4 of Shop No.134 of First Floor Covered With Material & Wooden Racks

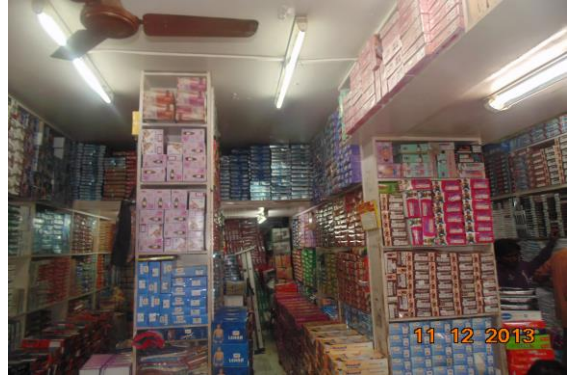
Photo 221

Wall No. 1 of Shop No.139 & 140 of First Floor Covered With Material & Wooden Racks

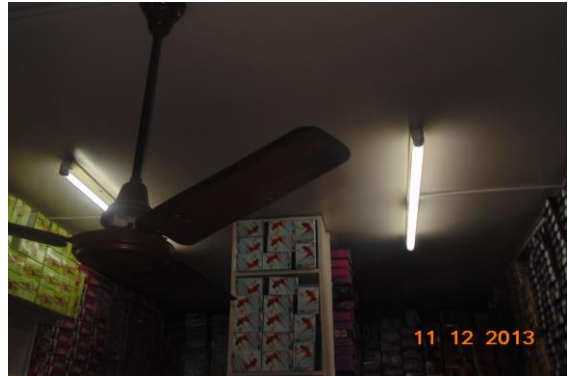
Photo 223

Roof of Shop No.139 & 140 of First Floor Covered With Wooden Work

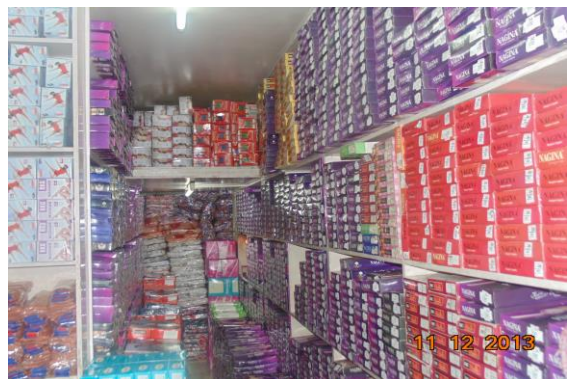
Photo 225

Wall No. 4 of Shop No.139 & 140 of First Floor Covered With Material & Wooden Racks

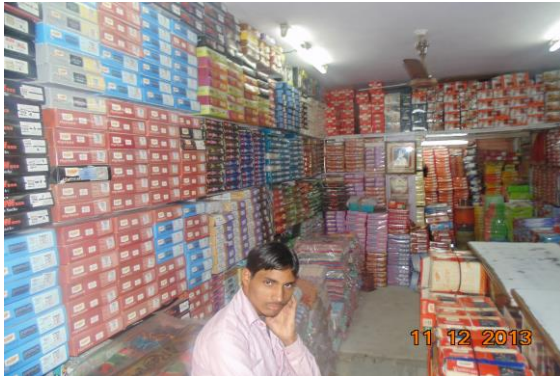
Photo 226

Wall No. 2 of Shop No.139 & 140 of First Floor Covered With Material & Wooden Racks

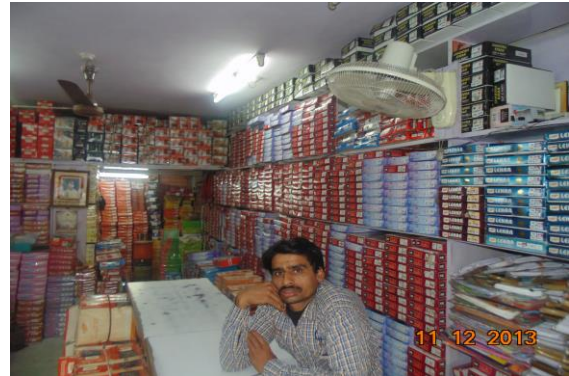
Photo 227

Wall No. 1 & 4 of Shop No.138 of First Floor Covered With Material & Wooden Racks

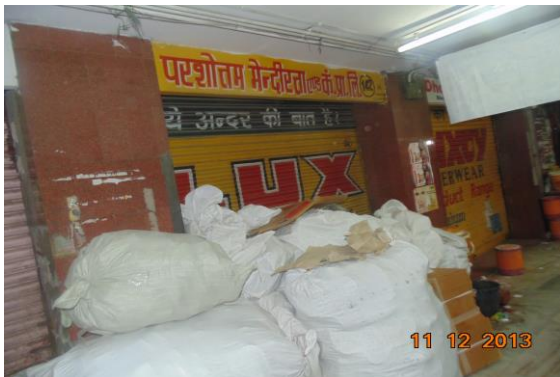
Photo 228

Wall No. 2 & 4 of Shop No.138 of First Floor Covered With Material & Wooden Racks

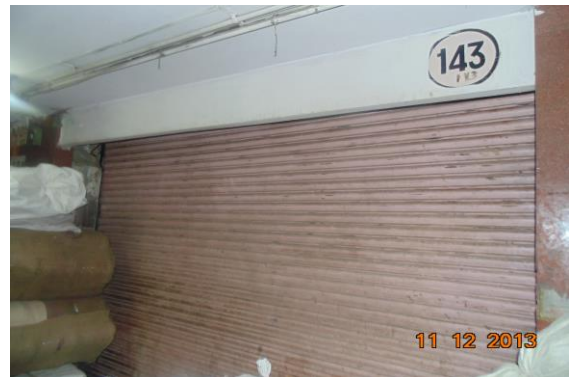
Photo 229

of Shop No.142 of First Floor Locked

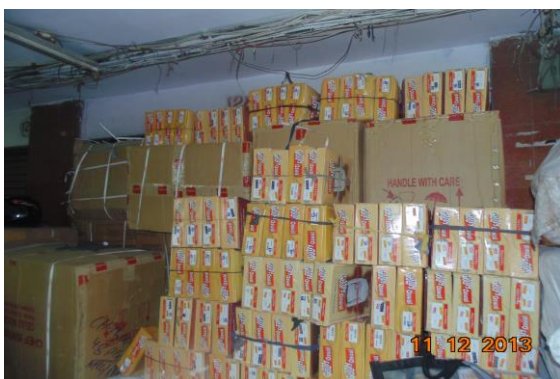
Photo 230

of Shop No.143 of First Floor Locked

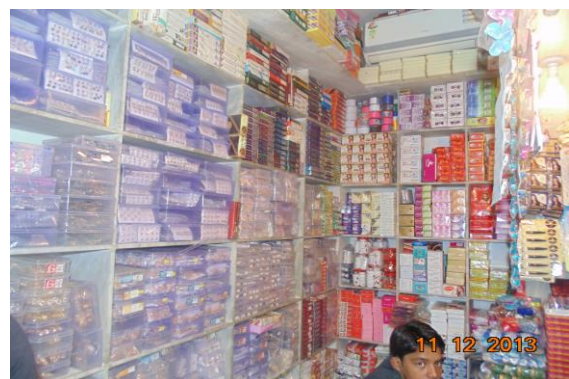
Photo 231

Shop No.128 of First Floor Locked

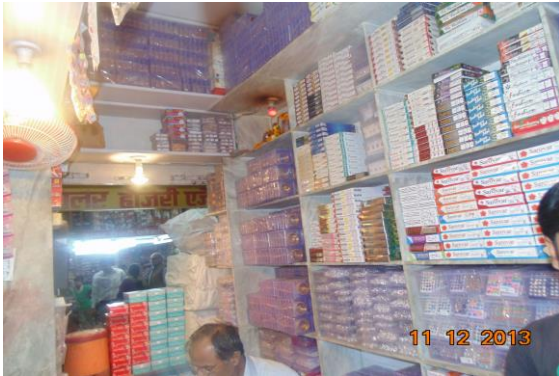
Photo 232

Wall No. 2 & 4 of Shop No.127 of First Floor Covered With Material & Wooden Racks

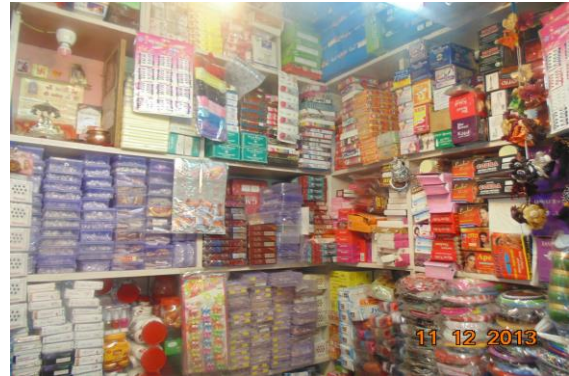
Photo 233

Wall No. 1 & 4 of Shop No.127 of First Floor Covered With Material & Wooden Racks

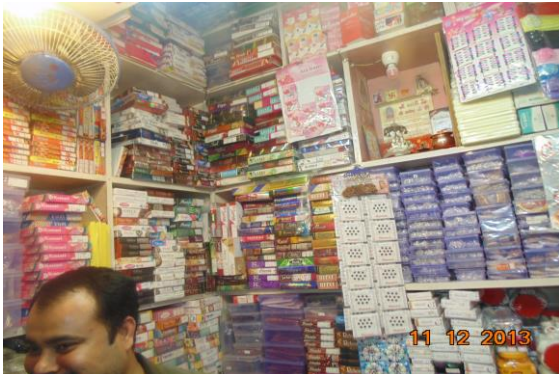
Photo 234

Wall No. 2 & 4 of Shop No.127 A of First Floor Covered With Material & Wooden Racks

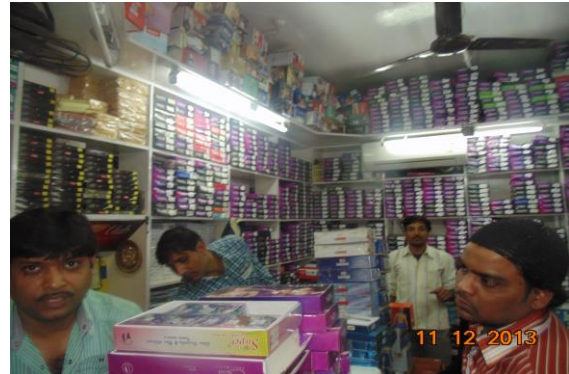
Photo 235

Wall No. 1 & 4 of Shop No.127 A of First Floor Covered With Material & Wooden Racks

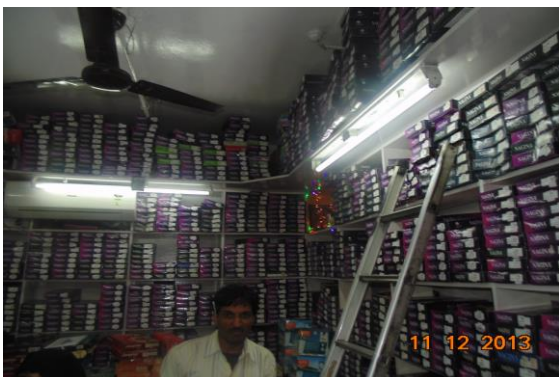
Photo 236

Wall No. 2 & 4 of Shop No.126 of First Floor Covered With Material & Wooden Racks

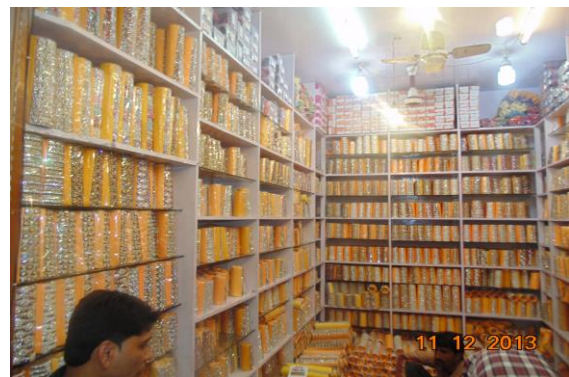
Photo 237

Wall No. 1 & 4 of Shop No.126 of First Floor Covered With Material & Wooden Racks

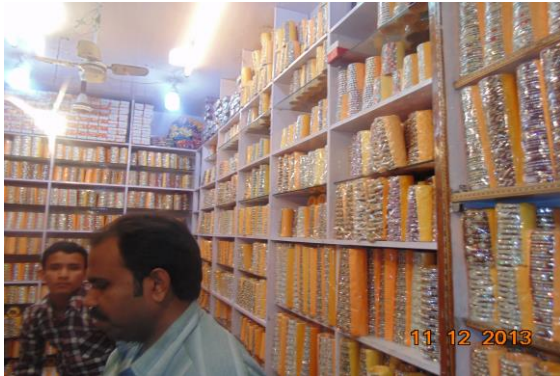
Photo 238

Wall No. 1 & 4 of Shop No.125 of First Floor Covered With Material & Wooden Racks

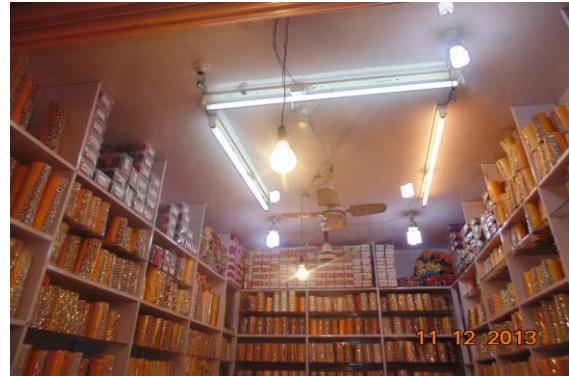
Photo 239

Wall No. 2 & 4 of Shop No.125 of First Floor Covered With Material & Wooden Racks

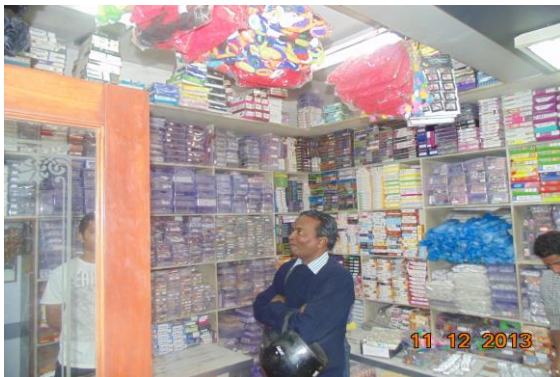
Photo 240

Roof of Shop No.125 of First Floor Covered With Wooden Works

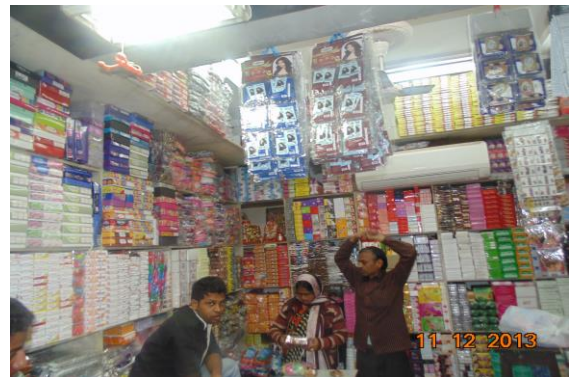
Photo 241

Wall No. 1 & 4 of Shop No.123 & 124 of First Floor Covered With Material & Wooden Racks

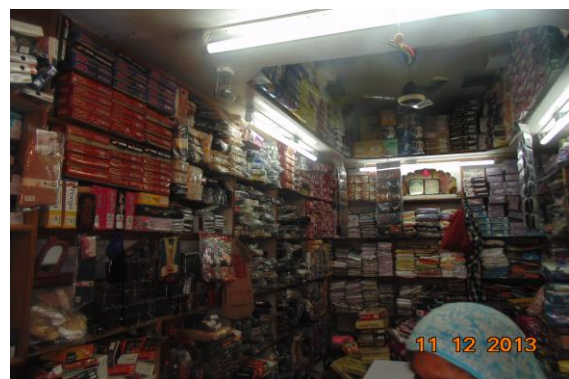
Photo 243

Roof of Shop No.123 & 124 of First Floor Covered With Wooden Works

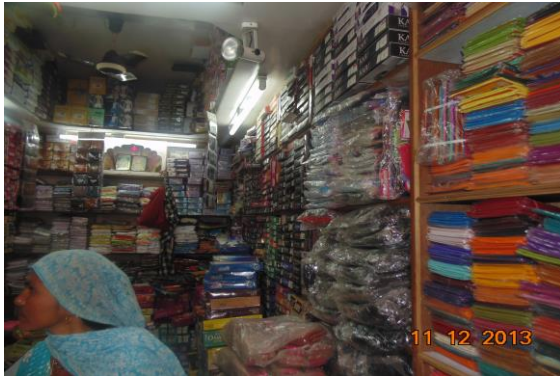
Photo 244

Wall No. 1 & 4 of Shop No.121 of First Floor Covered With Material & Wooden Racks

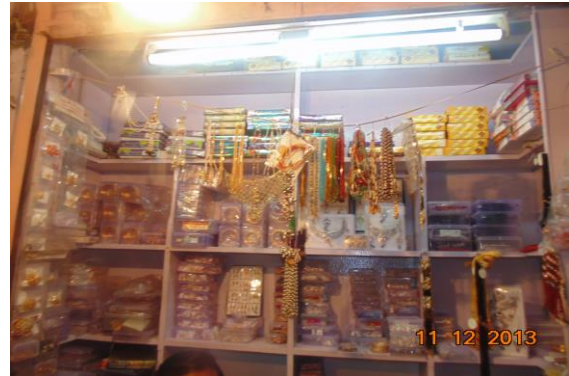
Photo 245

Wall No. 2 & 4 of Shop No.121 of First Floor Covered With Material & Wooden Racks

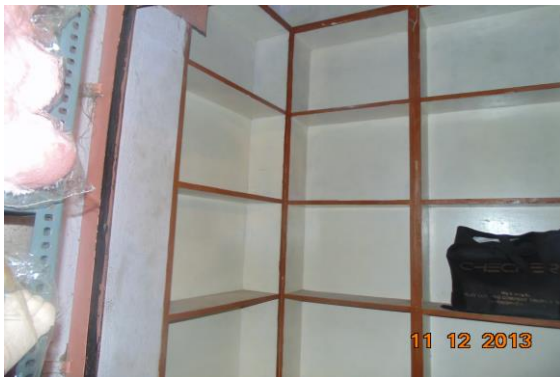
Photo 246

All Walls of Shop No.118 A of First Floor Covered With Material & Wooden Racks

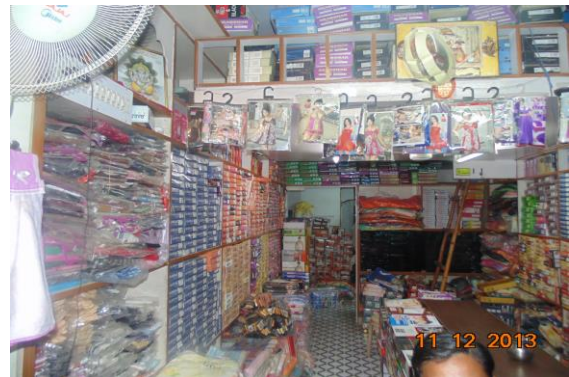
Photo 247

All Walls of Shop No.119 A of First Floor Covered With Material & Wooden Racks

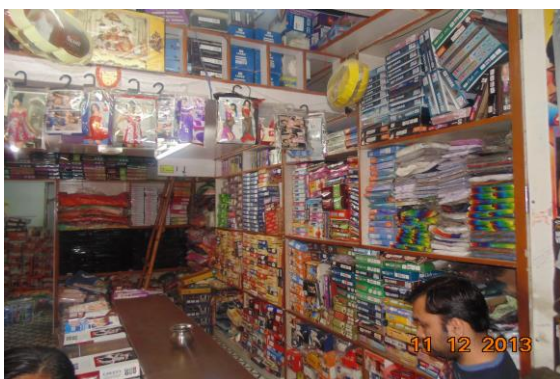
Photo 248

Wall No. 1 & 4 of Shop No.119 of First Floor Covered With Material & Wooden Racks

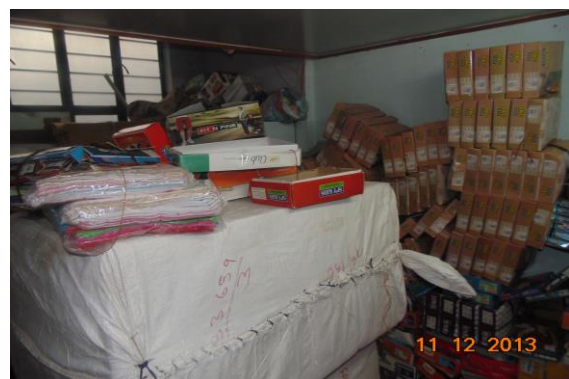
Photo 249

Wall No. 2 & 4 of Shop No.119 of First Floor Covered With Material & Wooden Racks

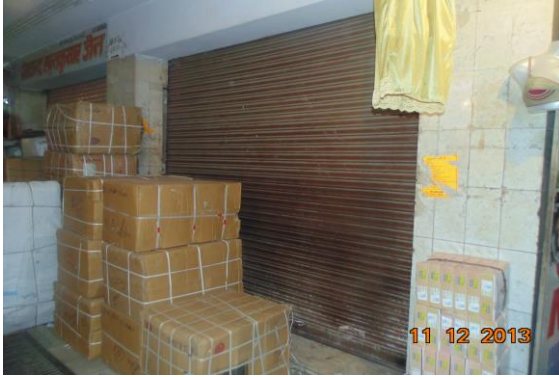
Photo 250

Shop No.119 of First Floor Covered With Material

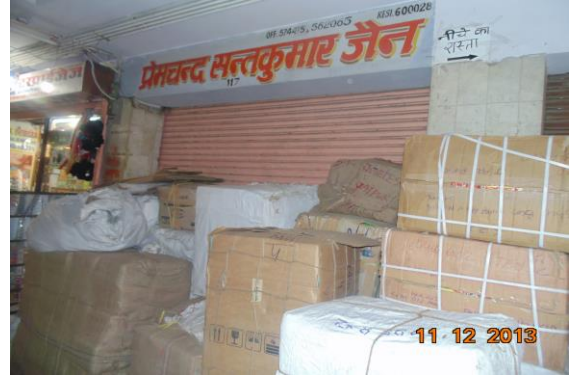
Photo 251
Shop No.117 of First Floor Locked

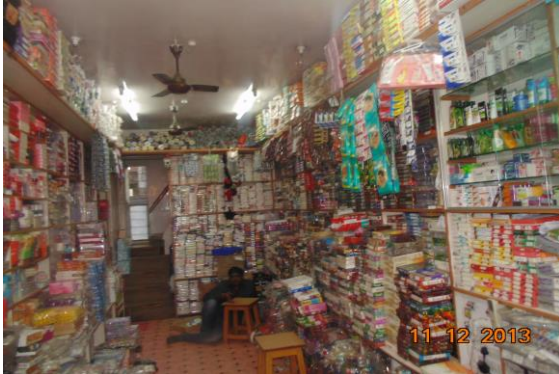
Photo 252
Shop No.116 of First Floor Locked

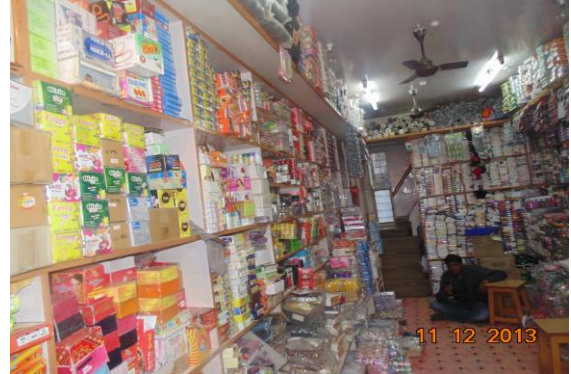
Photo 253
Wall No. 2 & 4 of Shop No.116 of First Floor Covered With Material & Wooden Racks

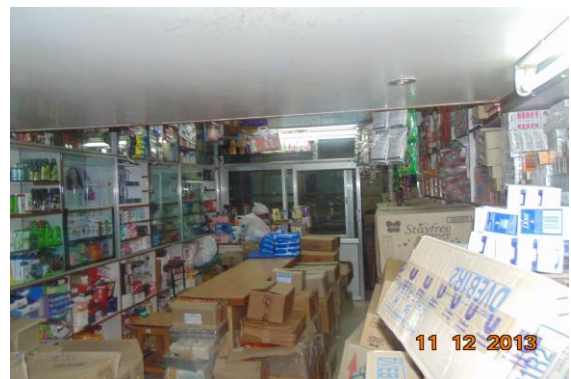
Photo 255
All Walls of Shop No.216 of First Floor Covered With Material & Wooden Racks

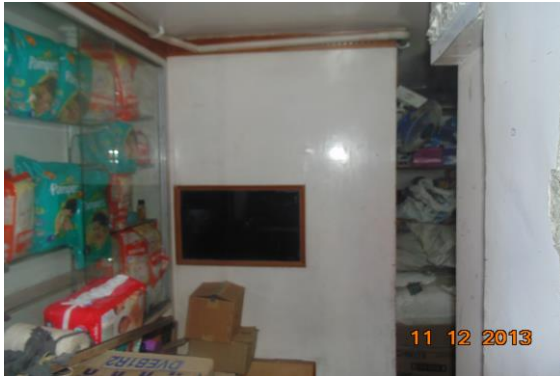
Photo 256
Shop No.217 of First Floor Way To second Floor

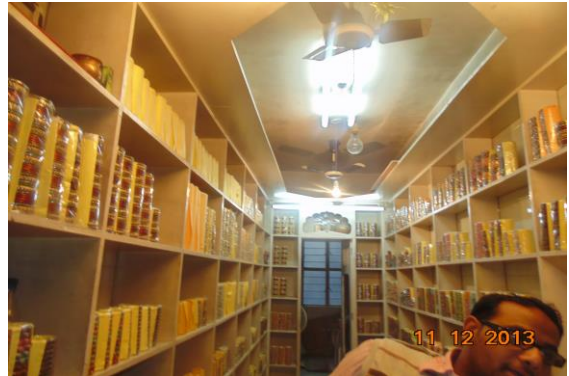
Photo 257
Shop No.217 of First Floor Way To second Floor

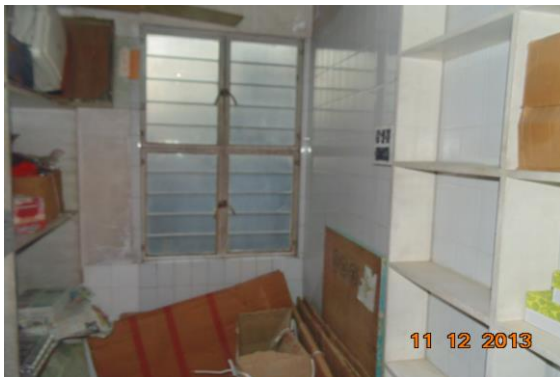
Photo 258
All Walls of Shop No.115 of First Floor Covered With Material & Wooden Racks

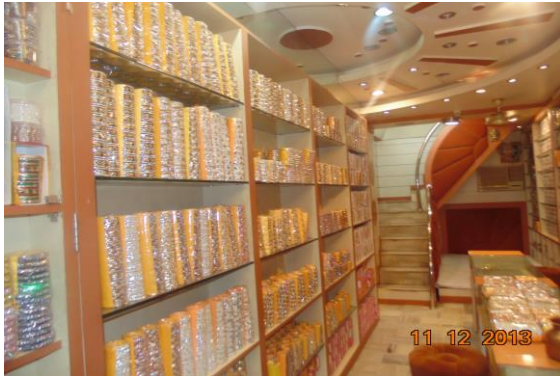
Photo 262
Wall No. 2 & 4 of Shop No.114 of First Floor Covered With Material & Wooden Racks

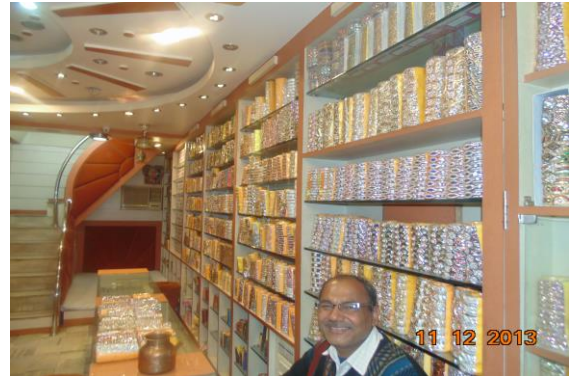
Photo 263

Wall No. 1 & 4 of Shop No.113 of First Floor Covered With Material & Wooden Racks

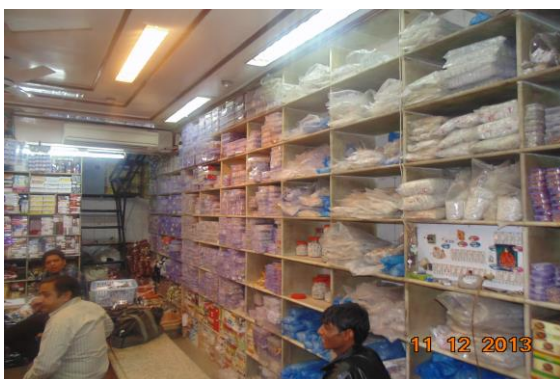
Photo 266

Wall No. 1 of Shop No.112 of First Floor Covered With Material & Wooden Racks

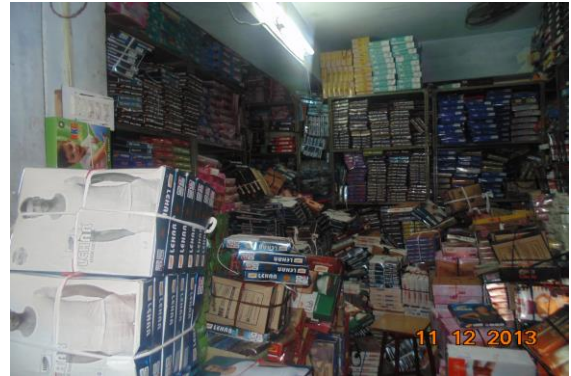
Photo 269

Wall No. 4 of Shop No.112 of First Floor Covered With Tiles Work

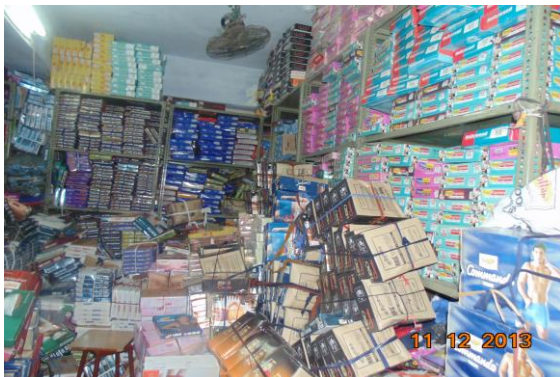
Photo 270

Wall No. 1 & 4 of Shop No.120 of First Floor Covered With Material & Wooden Racks

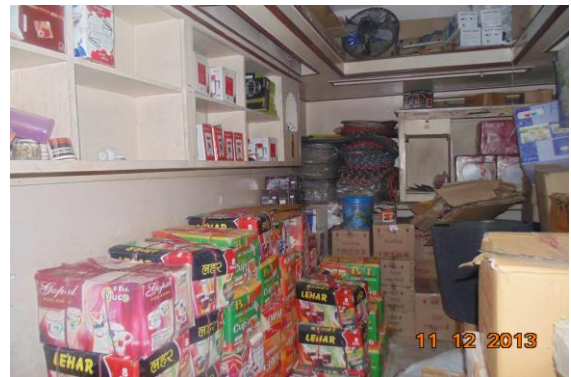
Photo 271

Wall No. 2 & 4 of Shop No.120 of First Floor Covered With Material & Wooden Racks

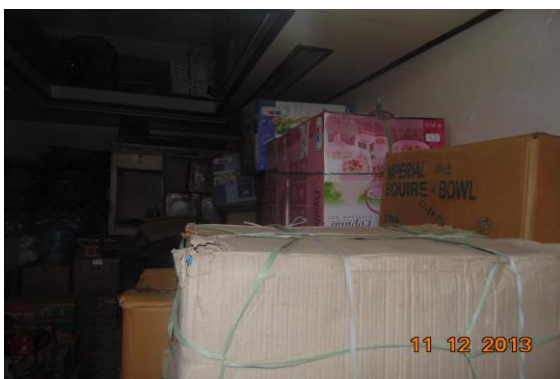
Photo 272

Wall No. 1 & 4 of Shop No.122 of First Floor Covered With Material & Wooden Racks

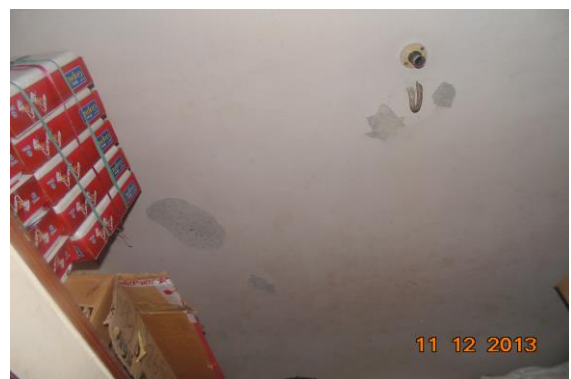
Photo 273

Wall No. 2 & 4 of Shop No.122 of First Floor Covered With Material & Wooden Racks

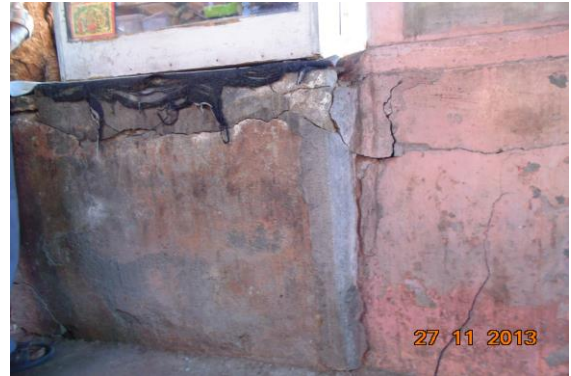
Photo 2
Damaged Portion on External Wall of Temple in front of Shop No. 19
Ground Floor

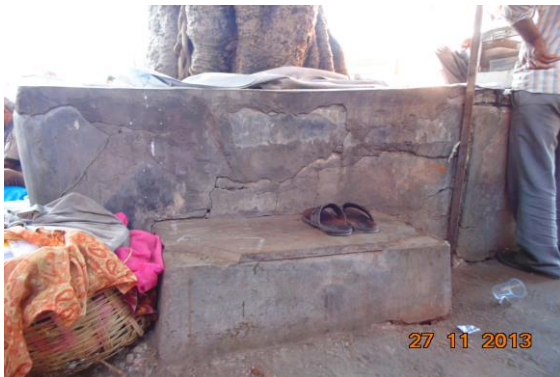
Photo 3
Damaged Portion of Temple in front of Shop No. 19 Ground Floor

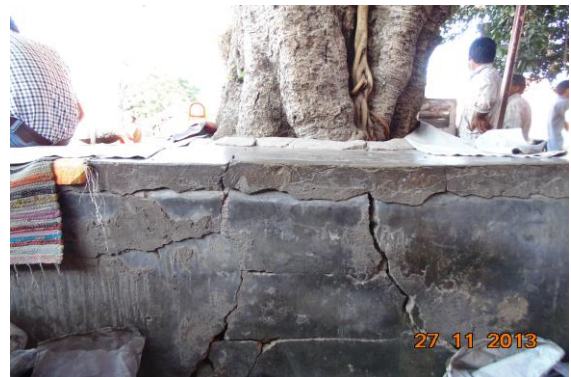
Photo 4
Damaged Portion of Temple in front of Shop No. 19 Ground Floor

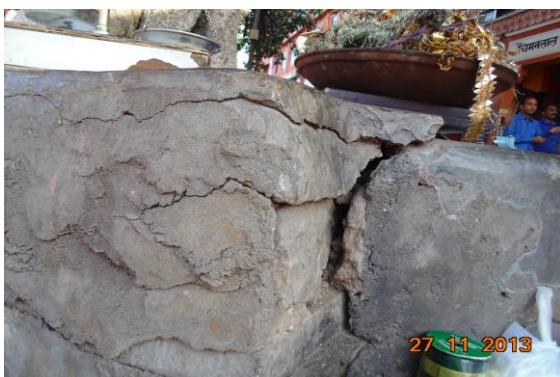
Photo 5
Damaged Portion of Temple in front of Shop No. 19 Ground Floor

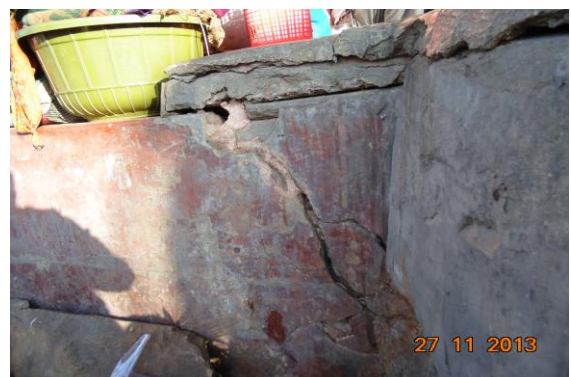
Photo 6
Damaged Portion of Temple in front of Shop No. 19 Ground Floor

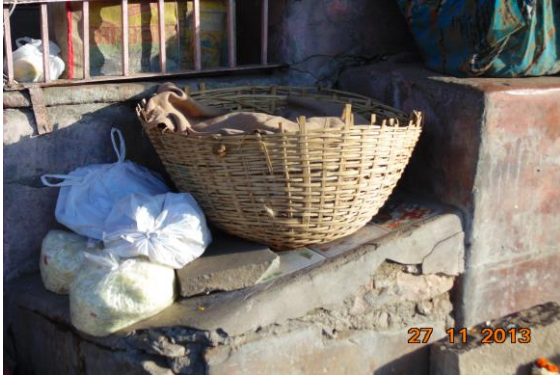
Photo 7

Damaged Portion of Temple in front of Shop No. 19 Ground Floor

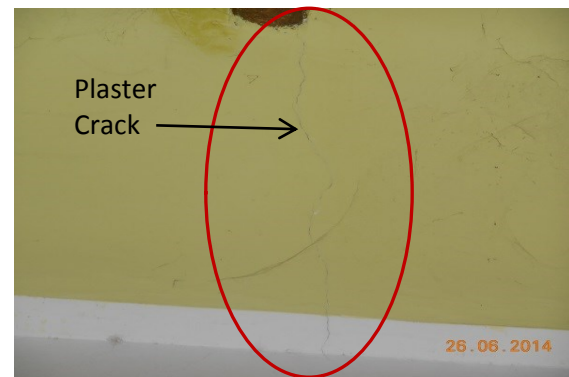
Photo 6
Plaster Crack on Wall No. 4 of Vandah of Temple, Ground Floor

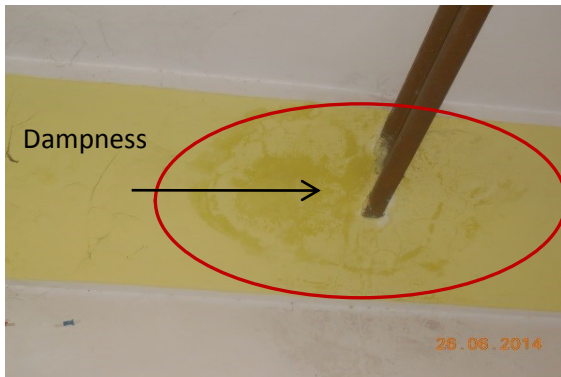
Photo 7

Dampness on Wall No. 4 of Vandah of Temple, Ground Floor

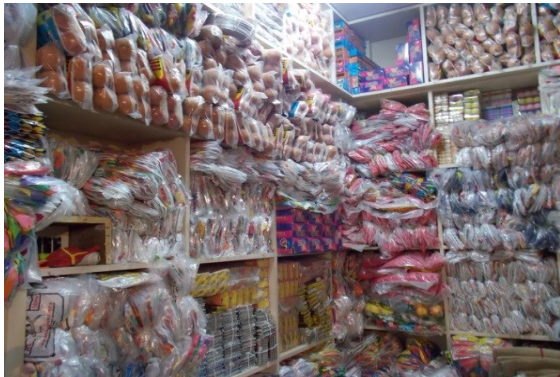
Photo 1

Covered with Material, Wall No. 1 & 4, Laddu Lal Godown, Shop No. B14, Basement

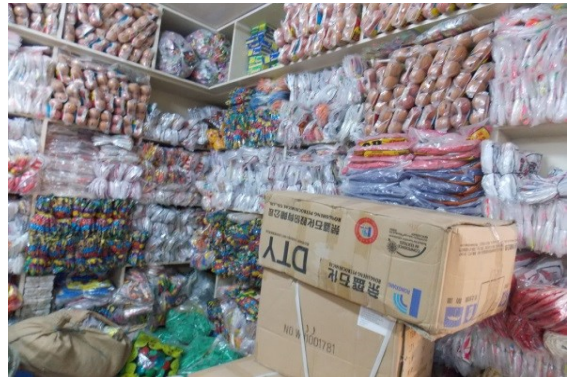
Photo 2

Covered with Material, Wall No. 2 & 4, Laddu Lal Godown, Shop No. B14, Basement

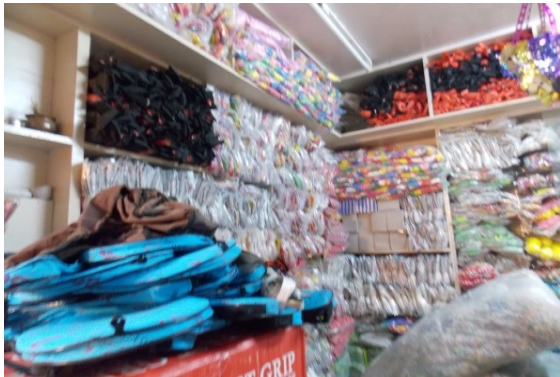
Photo 1

Covered with Material, Wall No. 1 & 4, Laddu Lal Godown, Shop No. B15, Basement

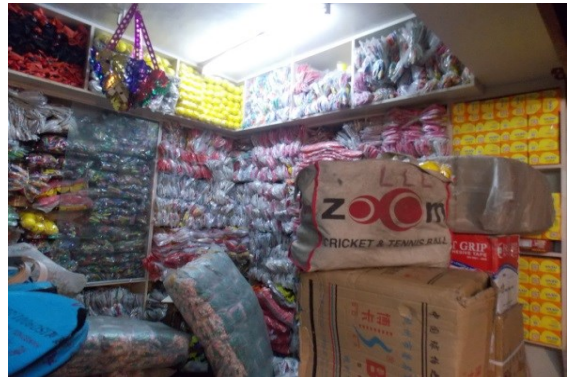
Photo 2

Covered with Material, Wall No. 2 & 4, Laddu Lal Godown, Shop No. B15, Basement

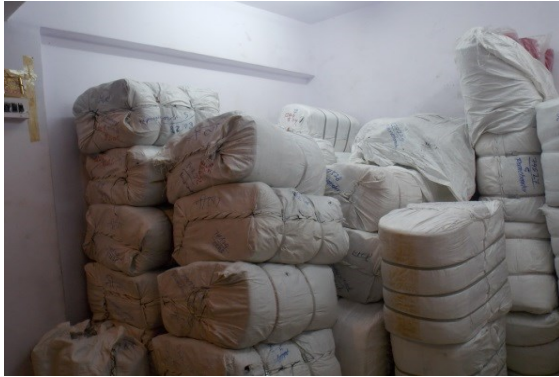
Photo 1

Covered with Material, Wall No. 1 & 4, Santoshlal Godown,
No. B16, Basement

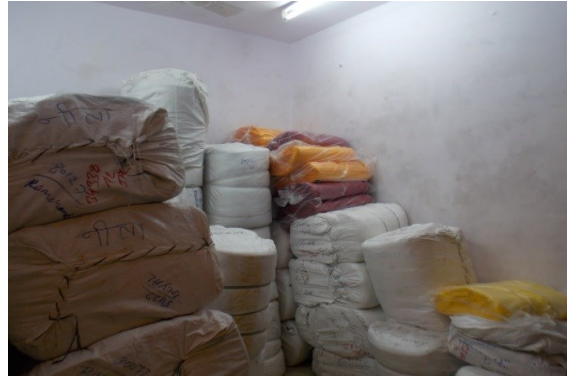
Photo 2

Covered with Material, Wall No. 2 & 4, Santoshlal Godown,
No. B16, Basement

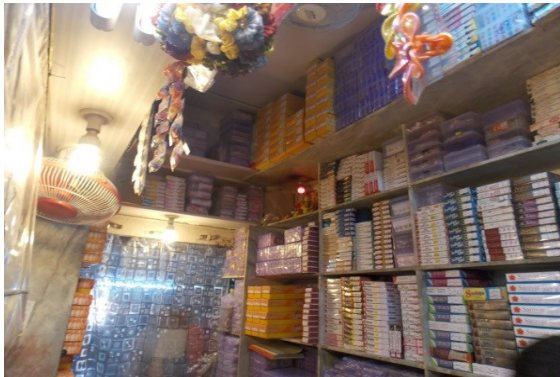
Photo 1

Covered with wooden and Material, Wall 1 & Wall 4 of Satguru Novelty,
127/B

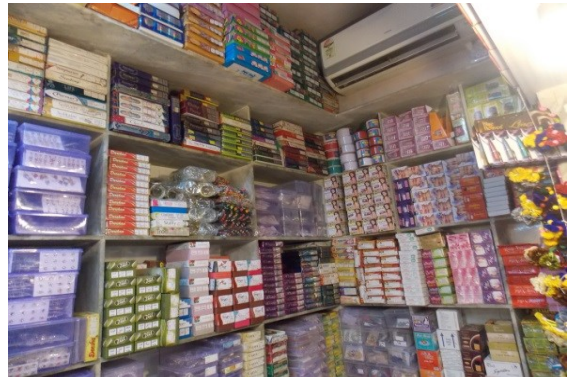
Photo 2

Covered with wooden and Material, Wall 2 & Wall 4 of Satguru Novelty,
127/B

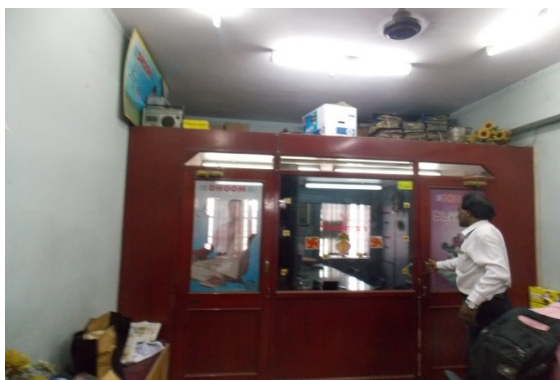
Photo 3

Wooden Partition on Shop No. 141, Dhoom Textiles, First Floor

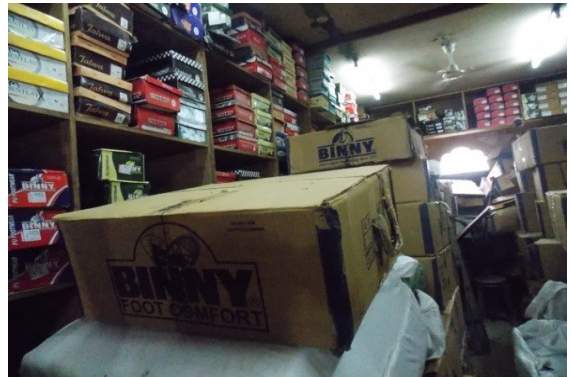
Photo 2

Covered with Materials, Wall No. 1 & 4 of Shop No. 148, J.P. Enterprises, First Floor

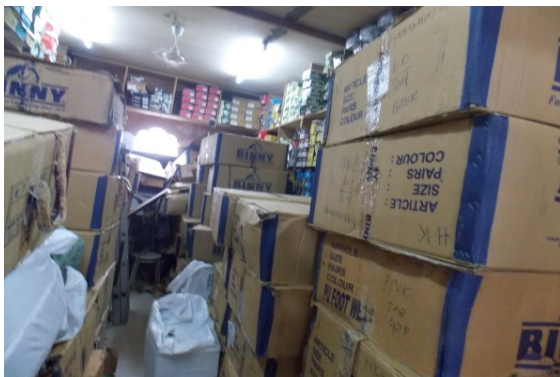
Photo 3

Covered with Materials, Wall No. 2 & 4 of Shop No. 148, J.P. Enterprises, First Floor

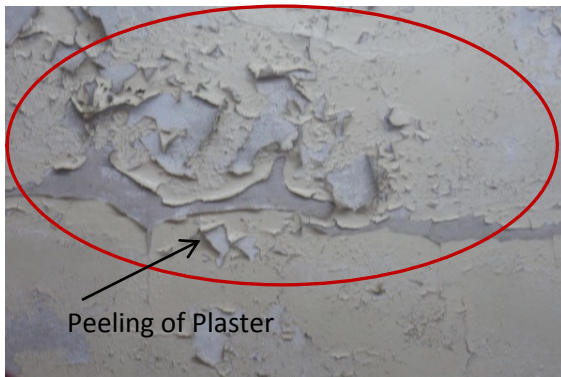
Photo 3

Peeling of Plaster on Roof of Shop No. 76, Ground floor

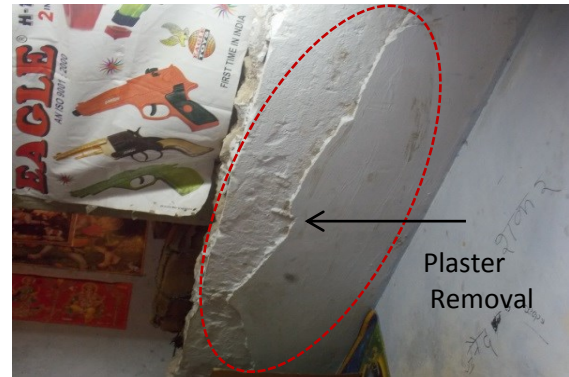
Photo 4

Plaster Removal on Stair Roof of Shop No. 76, Ground Floor

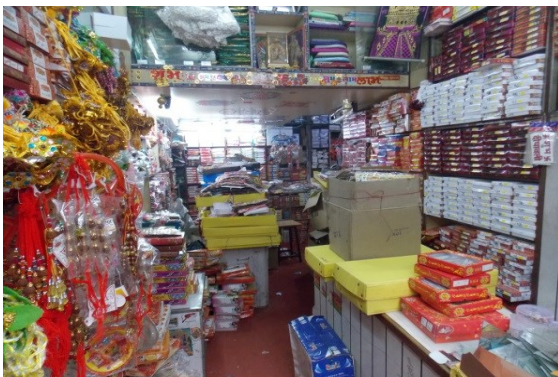
Photo 5

Covered with wood and Material, All Walls of Shop No. 76, Ground floor

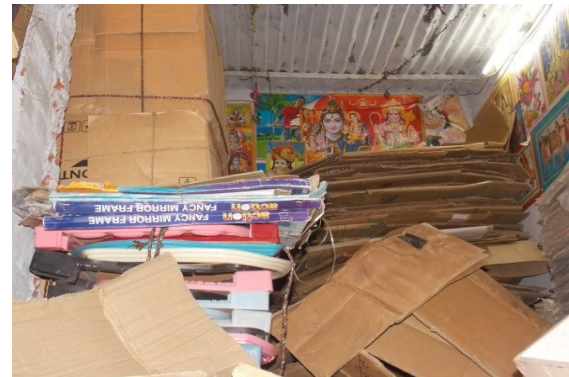
Photo 6

Covered with wood and Material, All Walls of Shop No. 76, First floor

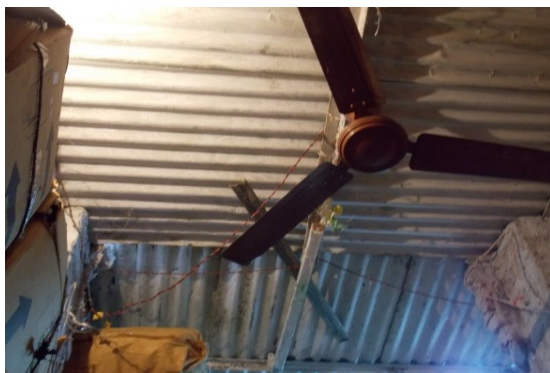
Photo 7

Tin Shade on Roof of Shop No. 76, First Floor

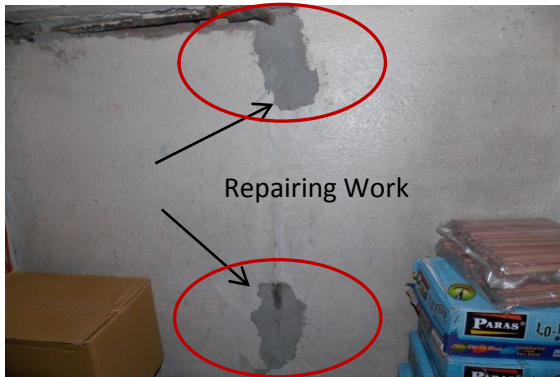
Photo 1

Repairing Work on Wall No.4 of Stair GF to FF of Shop No.81,Ground floor

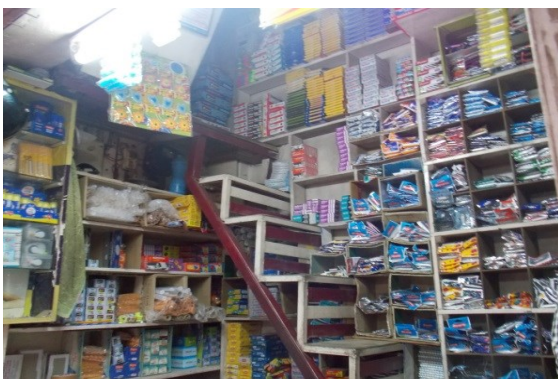
Photo 5

Covered with Material, Wall No. 1 & 4 of Shop No. 81, Ground floor

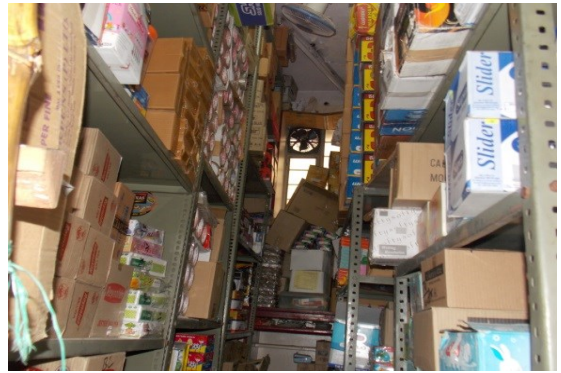
Photo 8

Covered with Material,, All Walls of Shop No. 81, First Floor

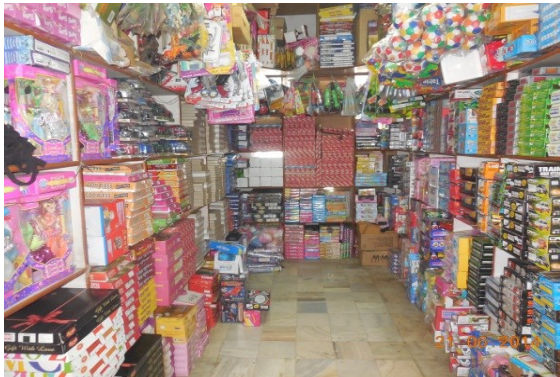
Photo 1

Covered with Material,, All Walls of Shop No. 235,Swastik Enterprises,
Second Floor

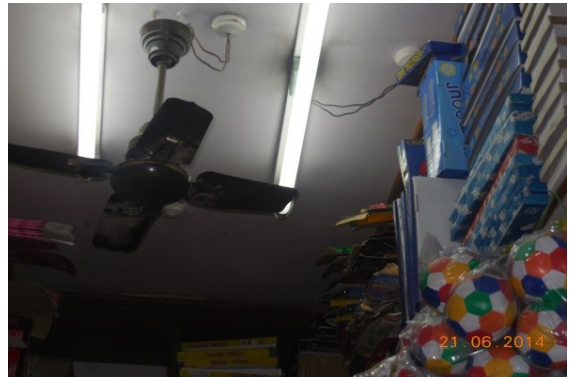
Photo 2

Covered with Wooden Ceiling, Roof of Shop No. 235,Swastik
Enterprises, Second Floor

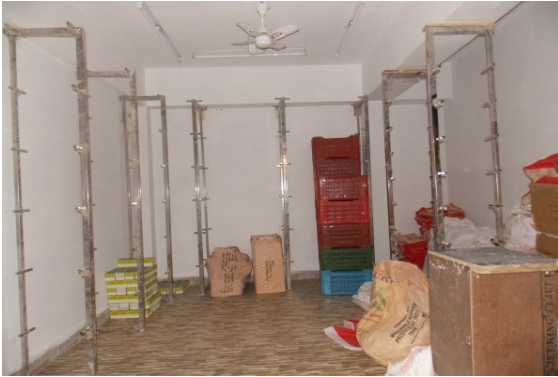
Photo 1

Covered with Material, Wall No. 4 of Shop No. 228, Mittal General Store,
Second Floor

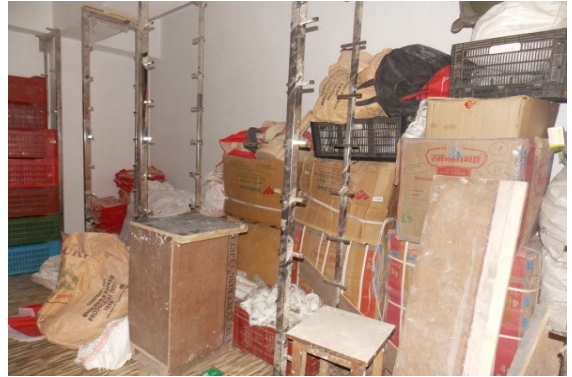
Photo 2

Covered with Material, Wall No. 2 of Shop No. 228, Mittal General Store,
Second Floor

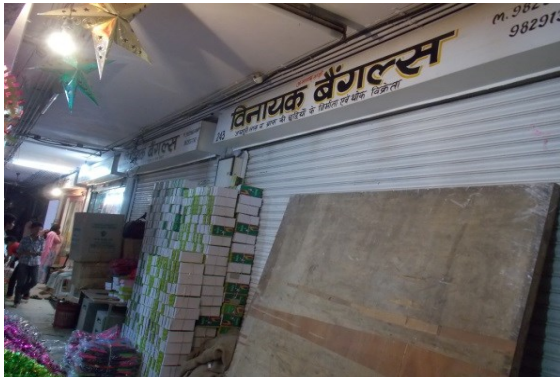
Photo 1

View of Shop No. 244 & 245 Vinayak Bangles, Second Floor

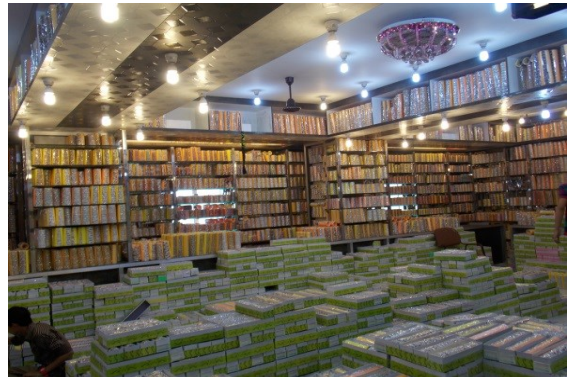
Photo 2

Covered with Material, Wall No. 4 of Shop No. 243,244 & 245, Vinayak Bangles, Second Floor

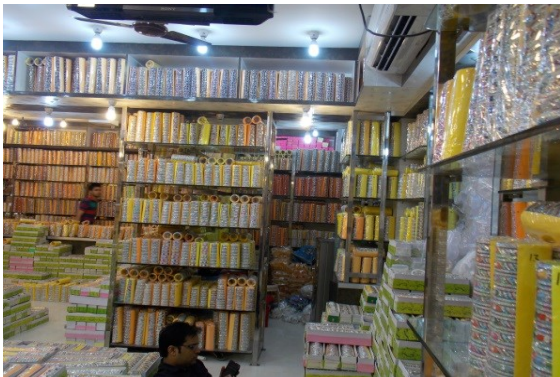
Photo 3

Covered with Material, Wall No. 2 & 3 of Shop No. 243,244 & 245, Vinayak Bangles, Second Floor

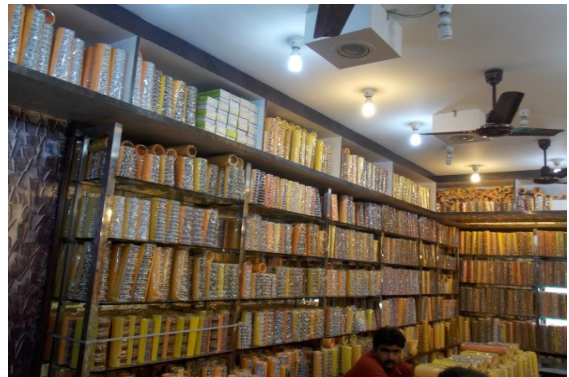
Photo 4

Covered with Material, Wall No. 1 & 4 of Shop No. 243,244 & 245, Vinayak Bangles, Second Floor
