### Pre Building Condition Survey Report

Name and Address of Structure :	Badi Chopar to Ramp Area (UP Line)
---------------------------------	------------------------------------

Name of the Project	<b>Contract JMRC-UG1B</b> “Design and Construction of Tunnel between Chandpole and Badi Chouper and reverse line by Shield TBM, Underground Metro Stations at Choti Chouper and Badi Chouper by Cut and Cover Methods on East West Corridor of Jaipur Metro Rail Corporation Limited .”	
Owner :

Pre Building Condition Survey Report Badi Chopar to Ramp Area (UP Line)

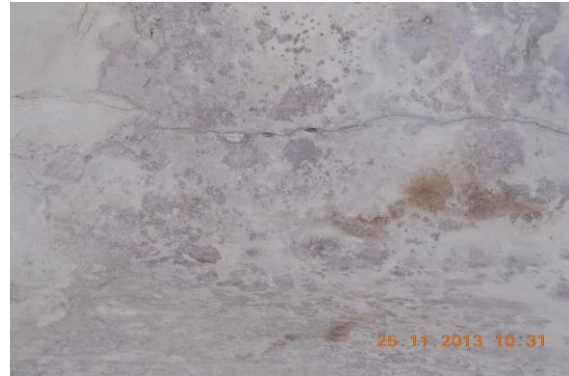
**Photo 26**  
Horizontal Crack on of Varanda of Shop No.381, Ground Floor  
Approx. Width = 0.2mm, Approx. Length = 2m.  
Distance from Leftside Wall = Backsidem, Height from Floor = 3m.

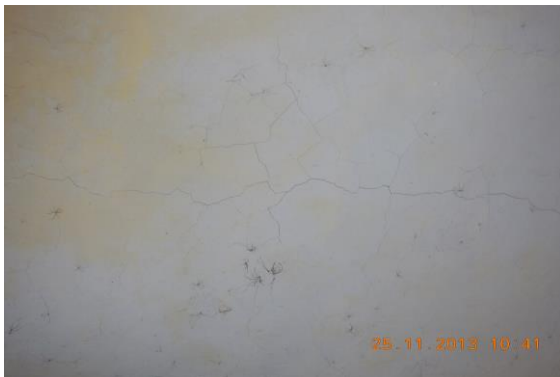
**Photo 27**  
Horizontal Crack on Roof of Shop No.376, Ground Floor  
Approx. Width = 0.8mm, Approx. Length = 2m.  
Distance from Wall No.3 = 0m, Height from Floor = 3m.

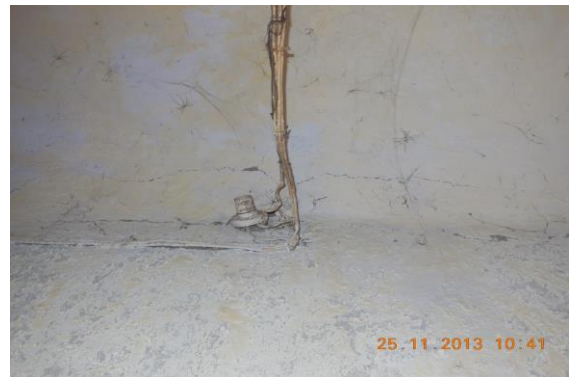
**Photo 28**  
Horizontal Crack on Wall No. 3 of Shop No.376, Ground Floor  
Approx. Width = 0.4mm, Approx. Length = 1.5m.  
Distance from Wall No.2 = 0m, Height from Floor = 2.8m.

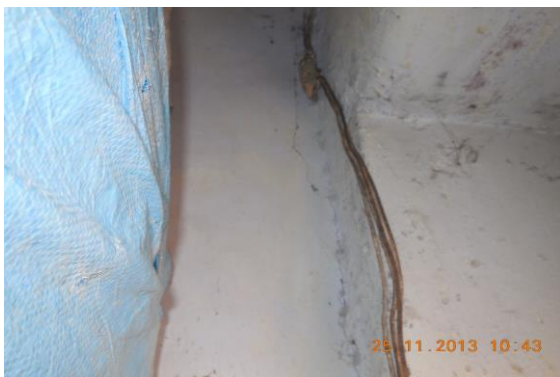
**Photo 29**  
Vertical Crack on Wall No. 2 of Shop No.376, Ground Floor. Approx. Width = 0.8mm, Approx. Length = 3m. Distance from Wall No.2 = 0m, Height from Floor = 0m.

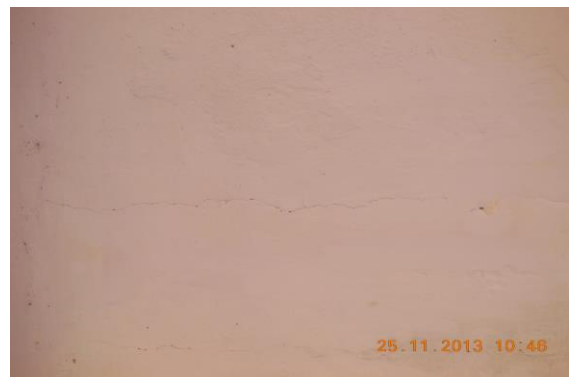
**Photo 30**  
Horizontal Crack on Roof of Varanda of Shop No.376, Ground Floor. Approx. Width = 2mm, Approx. Length = 1.7m. Distance from Leftside External Column = Backsidem, Height from Floor = 2.8m.

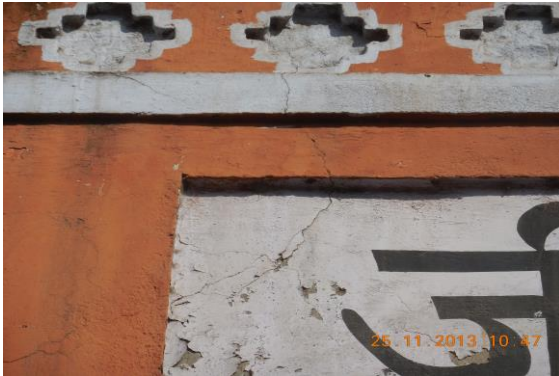
Photo 31

Inclined Crack on Outside & Left External column of Varanda of Shop No.376, Ground Floor Approx. Width = 0.2mm, Approx. Length = 1.2m. Distance from Leftside External Column = Frontsidem, Height from Floor = 2.5m

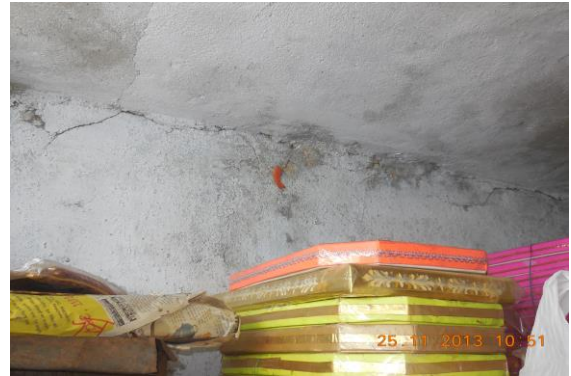
Photo 32

Inclined Crack on Wall No. 3 of Shop No.375, Ground Floor Approx. Width = 1.5mm, Approx. Length = 2.3m. Distance from Wall No.1 = 0m, Height from Floor = 3.2m.

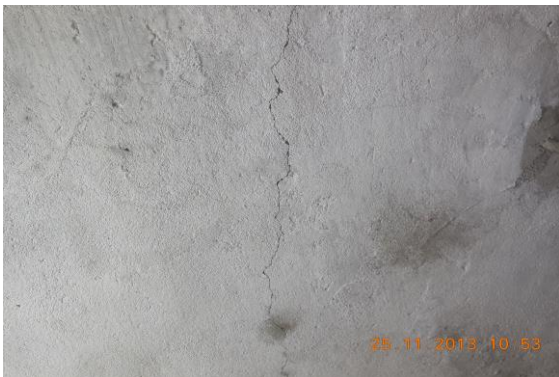
Photo 33

Horizontal Crack on Roof of Shop No.375, Ground Floor Approx. Width = 0.35mm, Approx. Length = 2m. Distance from Wall No.3 = 0m, Height from Floor = 3.2m.

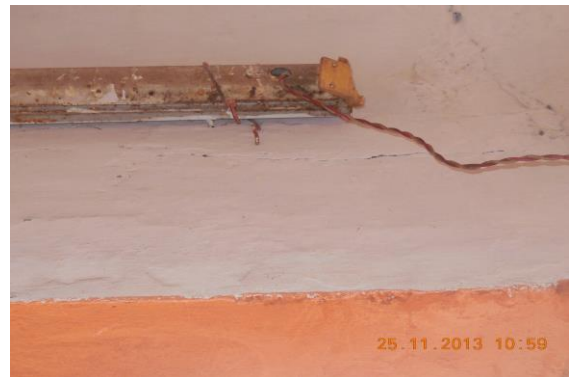
Photo 34

Horizontal Crack on Beam of Varanda of Shop No.376, Ground Floor Approx. Width = 0.5mm, Approx. Length = 2m. Distance from Leftside External Column = 0m, Height from Floor = 2.5m.

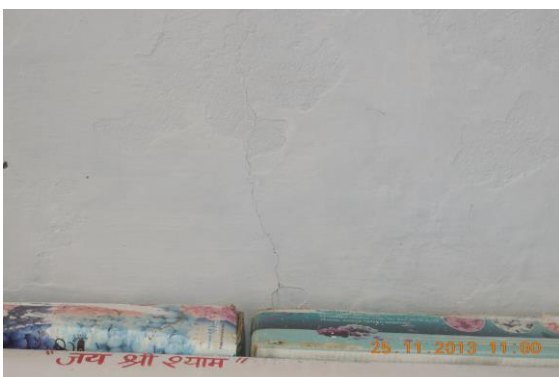
Photo 35

Horizontal Crack on Roof of Varanda of Shop No.376, Ground Floor Approx. Width = 0.1mm, Approx. Length = 2m. Distance from Leftside External Column = 1m, Height from Floor = 3m.

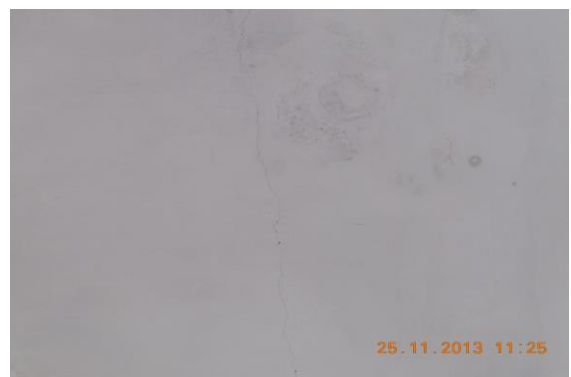
Photo 36

Horizontal Crack on Roof of Varanda of Shop No.379, Ground Floor Approx. Width = 0.1mm, Approx. Length = 2m. Distance from Leftside External Column = Backsidem, Height from Floor = 3m.

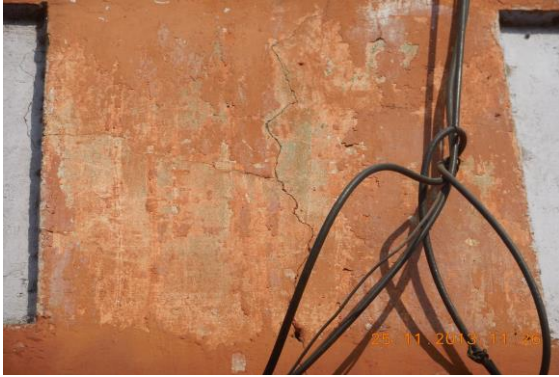
Photo 37

Inclined Crack on Right External Column of Varanda of Shop No.379, G/F Approx. Width = 0.4mm, Approx. Length = 0.6m. Distance from R/S External Column = 0m, Height from Floor = 2.2m.

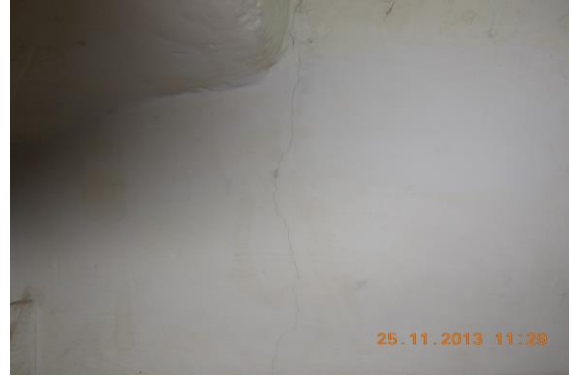
Photo 38

Inclined Crack on Wall No. 2 of Shop No.374, Ground Floor Approx. Width = 0.15mm, Approx. Length = 2.8m. Distance from Wall no.2 & 4 = Corner ofm, Height from Floor = 0.2m.

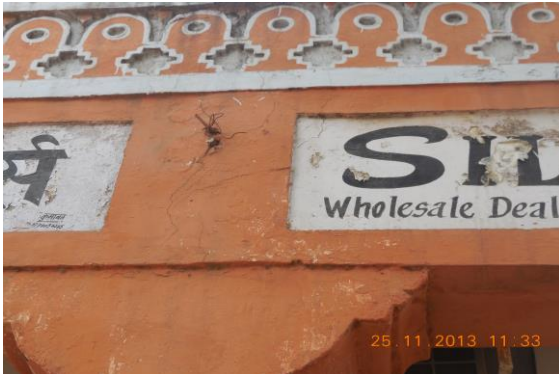
Photo 39

Inclined Crack on O/S & Left Ext. column of Varanda of Shop No.374, G/F Approx. Width = 0.2mm, Approx. Length = 1m. Dist. from L/S External Column = O/S, Height from Floor = 2.5m.

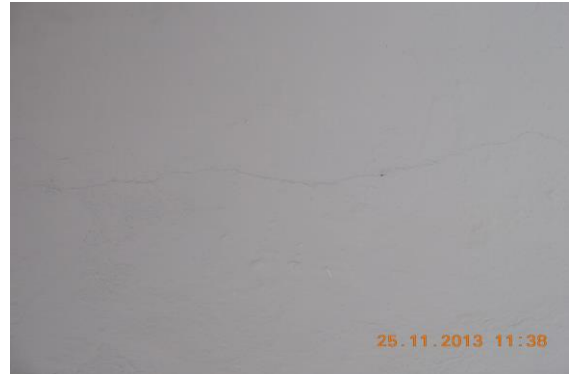
Photo 40

Horizontal Crack on Roof of Shop No.373, Ground Floor Approx. Width = 0.1mm, Approx. Length = 1.8m. Distance from Wall No.2 = 1m, Height from Floor = 3m.

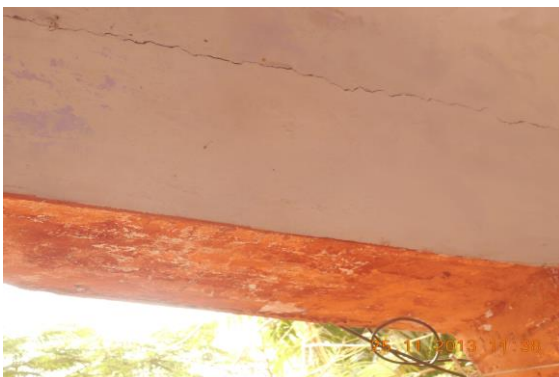
Photo 41

Horizontal Crack on Roof of Varanda of Shop No.373, Ground Floor Approx. Width = 2mm, Approx. Length = 14m. Distance from = Internal Beam wall no.3m, Height from Floor = 2.8m.

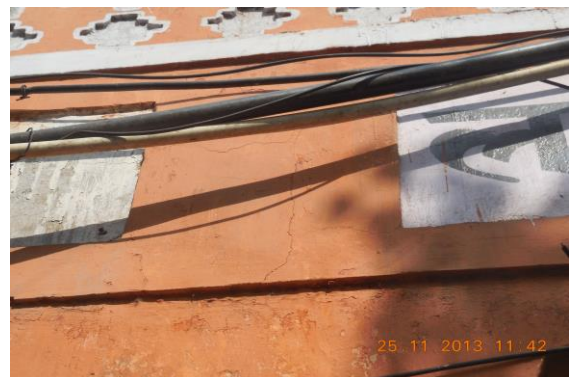
Photo 42

Horizontal Crack on Right External Column of Varanda of Shop No.373, G/F Approx. Width = 0.2mm, Approx. Length = 1m. Dist. from Rightside External Column = 0m, Height from Floor = 2.8m.

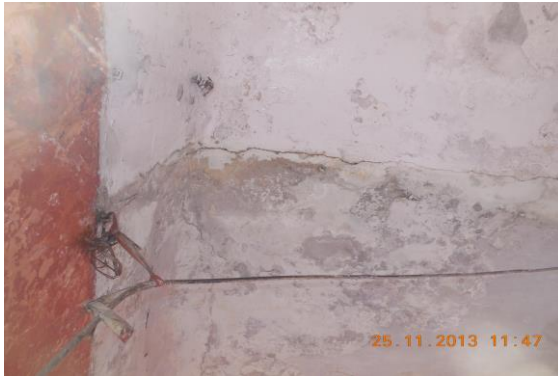
Photo 43

Horizontal Crack on Wall No. Backside & Left External column of Varanda of Shop No.371, Ground Floor  
Approx. Width = 0.8mm, Approx. Length = 2m.  
Distance from Leftside External Column = Backsidem. Height from Floor

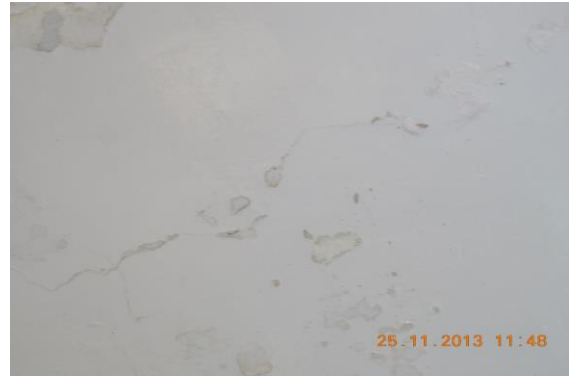
Photo 44

Horizontal Crack on Roof of Varanda of Shop No.371, Ground Floor  
Approx. Width = 0.1mm, Approx. Length = 2m.  
Distance from Rightside External Column = 0.3m, Height from Floor = 3m.

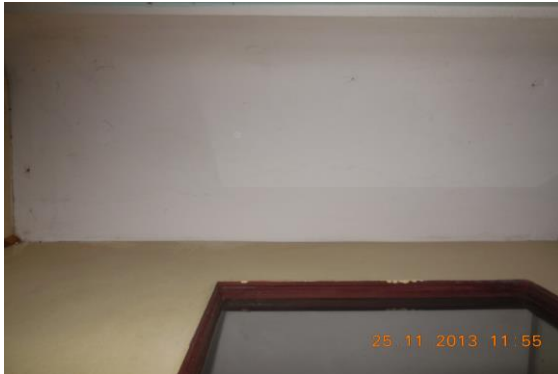
Photo 45

Inclined Crack on Roof of Shop No.370, Upper Ground Floor  
Approx. Width = 0.15mm, Approx. Length = 1.5m.  
Distance from Wall No.2 = 3m, Height from Floor = 1m.

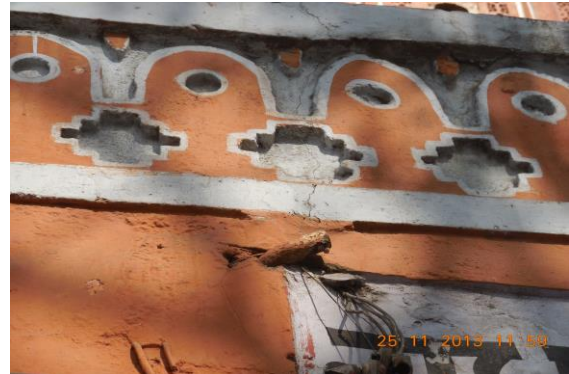
Photo 46

Inclined Crack on Leftside External Column of Shop No.370, G/F  
Approx. Width = 0.2mm, Approx. Length = 0.6m. Distance from Leftside External Column = 0m, Height from Floor = 3m.

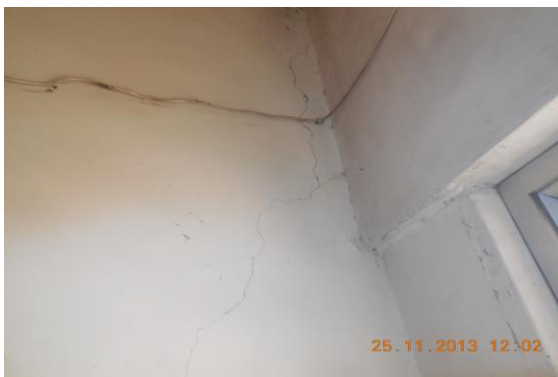
Photo 47

Inclined Crack on Wall No. 2 of Shop No.377, Ground Floor  
Approx. Width = 0.4mm, Approx. Length = 1.2m.  
Distance from Wall No.3 = 0m, Height from Floor = 1.4m.

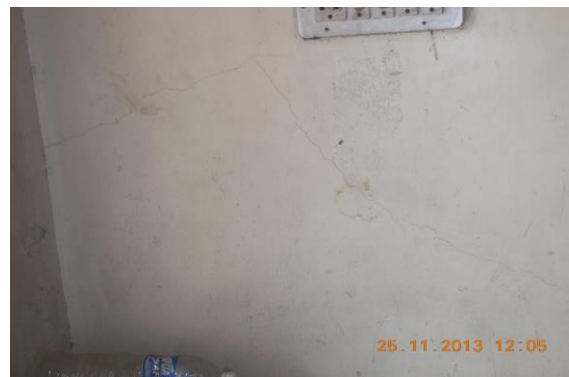
Photo 48

Inclined Crack on Wall No. 1 of Shop No.377, Ground Floor  
Approx. Width = 0.15mm, Approx. Length = 1.1m.  
Distance from Wall no.3 = 0m, Height from Floor = 1.3m.

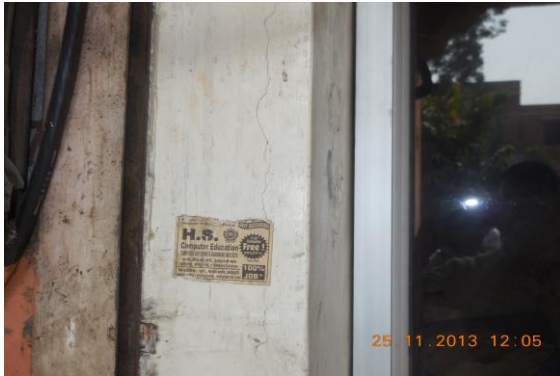
Photo 49

Vertical Crack on L/S External Column of Varanda of Shop No.377, G/F  
Approx. Width = 0.1mm, Approx. Length = 2m. Dist. from = L/S Internal Column, Height from Floor = 0.7m.

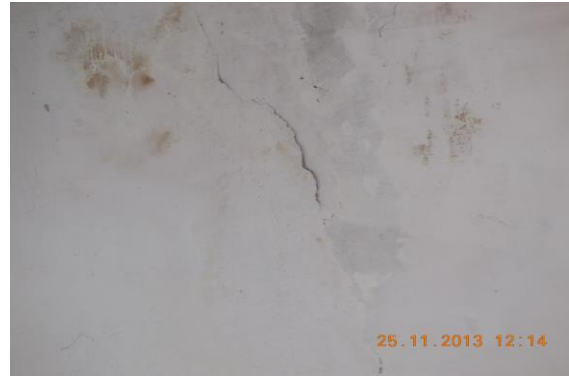
Photo 50

Horizontal Crack on Varanda of Shop No.369, Ground Floor Approx.  
Width = 0.1mm, Approx. Length = 2m. Distance from Leftside External Column = Backsidem, Height from Floor = 3m.

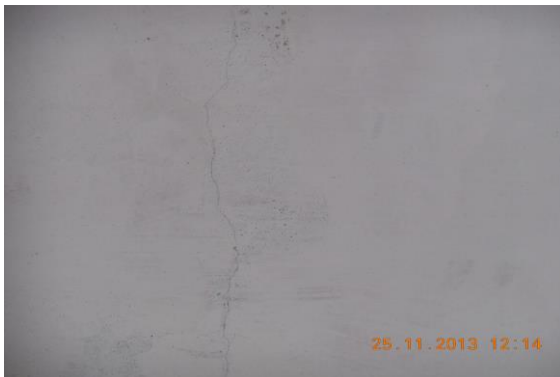
Photo 51

Horizontal Crack on Varanda of Shop No.369, Ground Floor  
Approx. Width = 0.1mm, Approx. Length = 2m.  
Distance from Leftside External Column = 1m, Height from Floor = 3m.

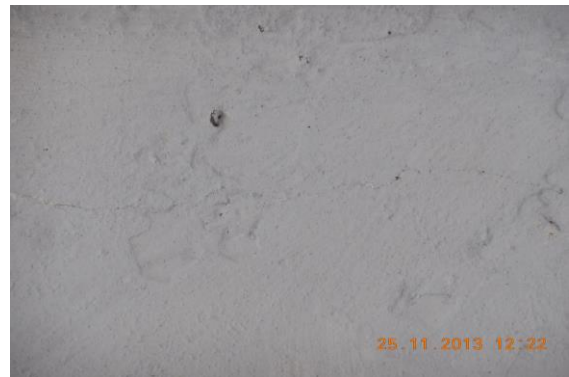
Photo 52

Horizontal Crack on Roof of Varanda of Shop No.367, Ground Floor  
Approx. Width = 0.1mm, Approx. Length = 2m. Distance from Leftside External Column = Backsidem, Height from Floor = 3m.

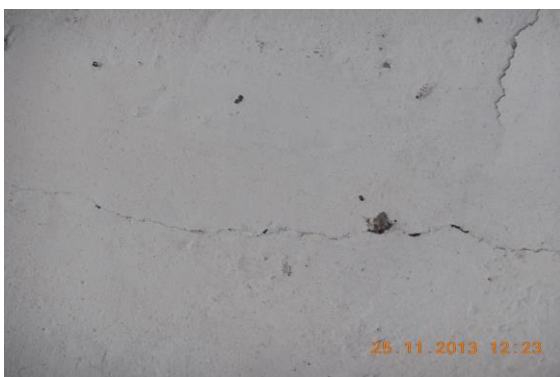
Photo 53

Horizontal Crack on Roof of Varanda of Shop No.367, Ground Floor  
Approx. Width = 0.15mm, Approx. Length = 2m. Distance from Leftside External Column = 0.4m, Height from Floor = 3m.

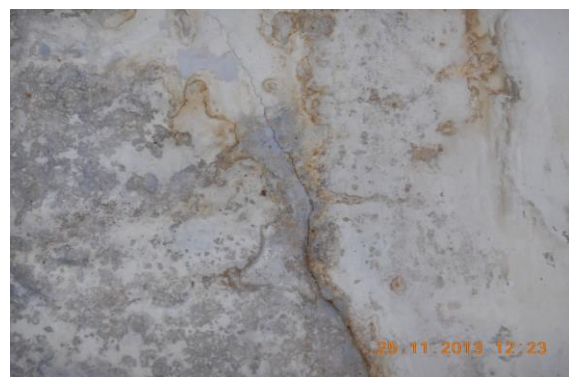
Photo 54

Horizontal Crack on Roof of Varanda of Shop No.367, Ground Floor  
Approx. Width = 0.4mm, Approx. Length = 2m. Distance from Rightside External Column = Backsidem, Height from Floor = 3m.

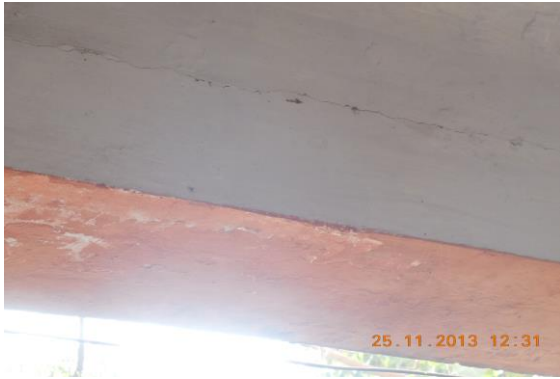
Photo 55

Horizontal Crack on Roof of Varanda of Shop No.365, Ground Floor  
Approx. Width = 0.8mm, Approx. Length = 3.2m. Distance from  
Rightside External Column = 0m, Height from Floor = 2.8m.

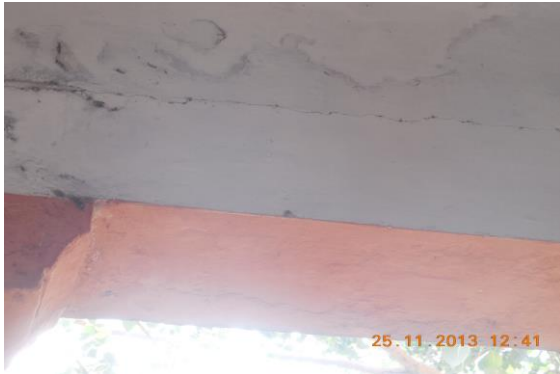
Photo 57

Horizontal Crack on Beam of Varanda of Shop No.366, Ground Floor  
Approx. Width = 0.2mm, Approx. Length = 3.2m. Dist. from Rightside  
External Column = Backsidem, Height from Floor = 2.5m.

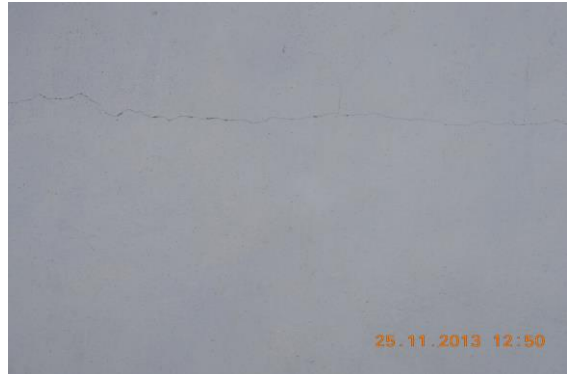
Photo 58

Horizontal Crack on Roof of Room No. 2, Ground Floor Approx. Width =  
0.35mm, Approx. Length = 2.7m. Distance from Wall No.1 = 1.3m,  
Height from Floor = 4m.

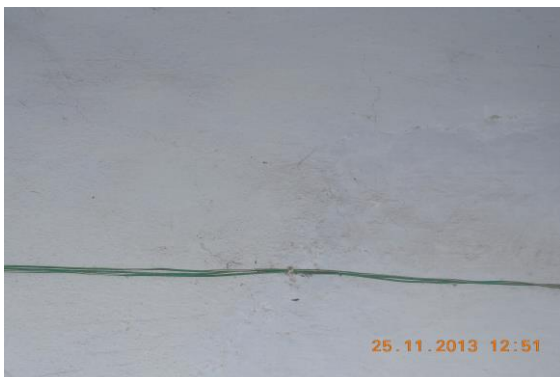
Photo 59

Inclined Crack on Wall No. 1 of Room No. 2, Ground Floor  
Approx. Width = 0.2mm, Approx. Length = 1.4m.  
Distance from Wall No.3 = 0m, Height from Floor = 3.5m.

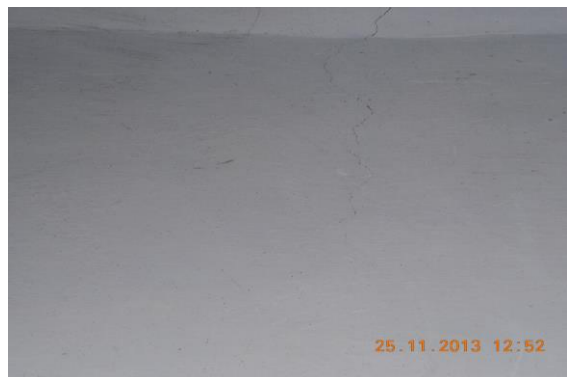
Photo 60

Inclined Crack on Wall No. 2 of Room No. 2, Ground Floor  
Approx. Width = 0.3mm, Approx. Length = 1m.  
Distance from Wall No.4 = 1.4m, Height from Floor = 3.2m.

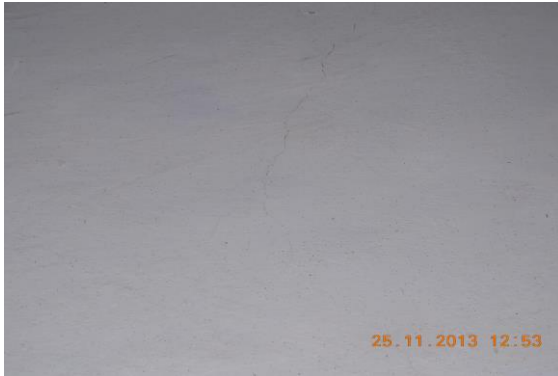
Photo 61

Inclined Crack on Wall No. 2 of Room No. 2, Ground Floor  
Approx. Width = 0.35mm, Approx. Length = 1.3m.  
Distance from Wall No.4 = 0.7m, Height from Floor = 2.4m.

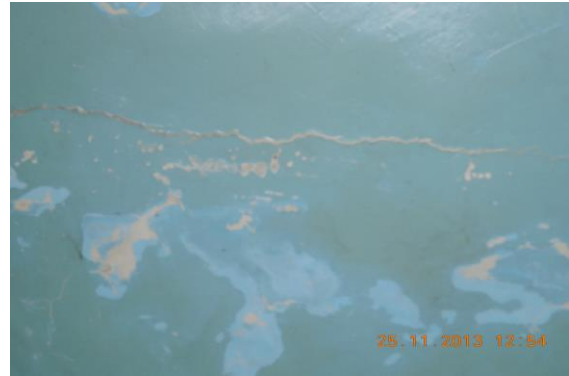
Photo 62

Horizontal Crack on Roof of Shop No.363, Ground Floor  
Approx. Width = 0.15mm, Approx. Length = 1.5m.  
Distance from Wall No.3 = 0.15m, Height from Floor = 3.2m.

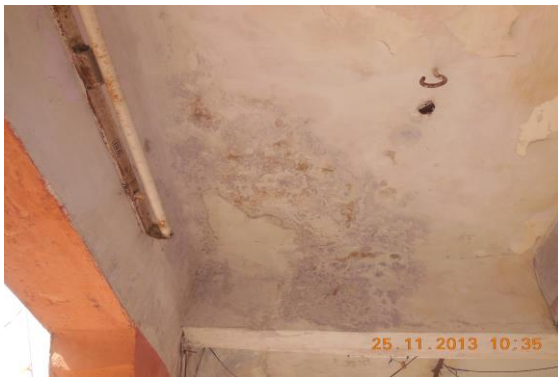
Photo 63

Dampness/Seepage on Roof of Shop No.380 of Ground Floor

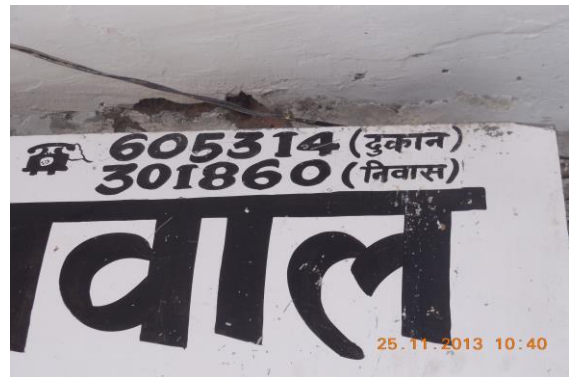
Photo 64

Dampness/Seepage on Roof of Varanda of Shop No.378 of Ground Floor

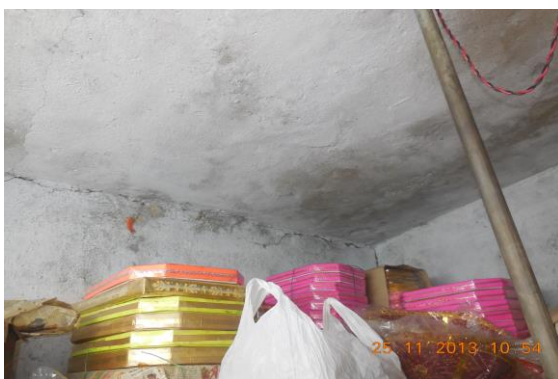
Photo 65

Dampness/Seepage on Wall No. 3 of Shop No.375 of Ground Floor

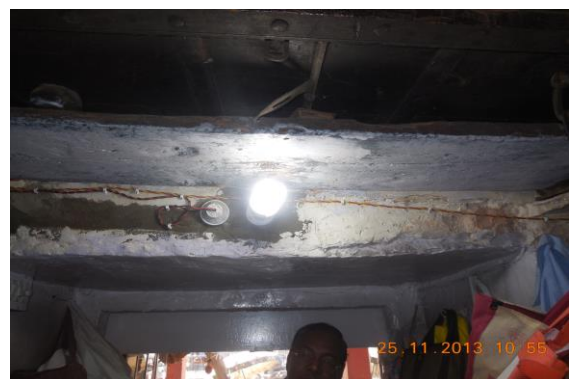
Photo 66

Peeling of Plaster on Wall No. 3 of Room No. 1 of Ground Floor

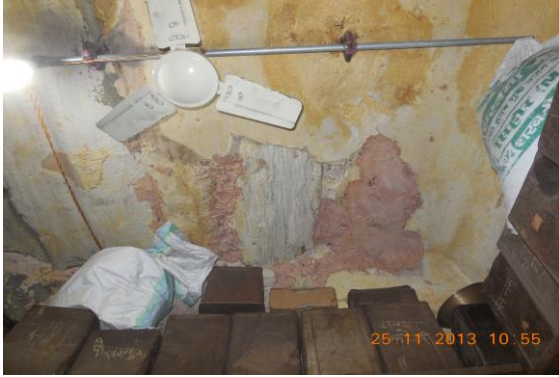
Photo 67

Damaged Portion on Roof of Room No. 1 of Ground Floor

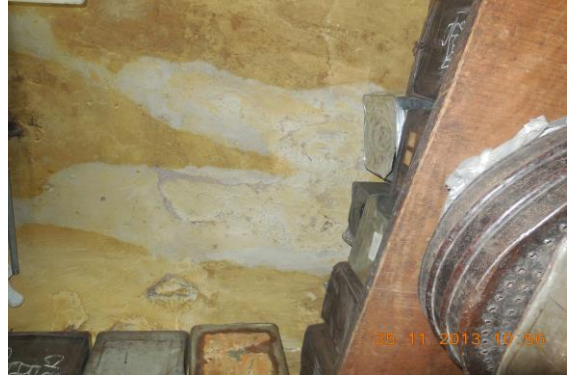
Photo 68

Damaged Portion on Roof of Room No. 1 of Ground Floor

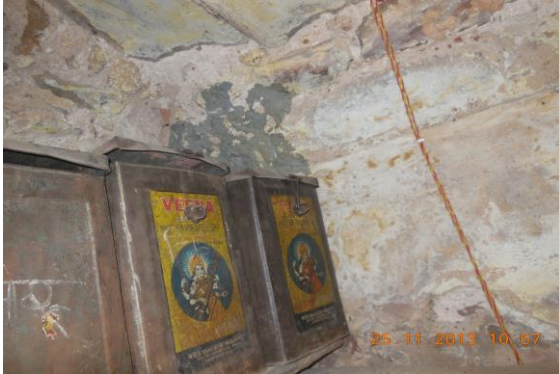
Photo 69

Damaged Portion on Wall No. 2, 1 & Roof of Room No. 1 of Ground Floor

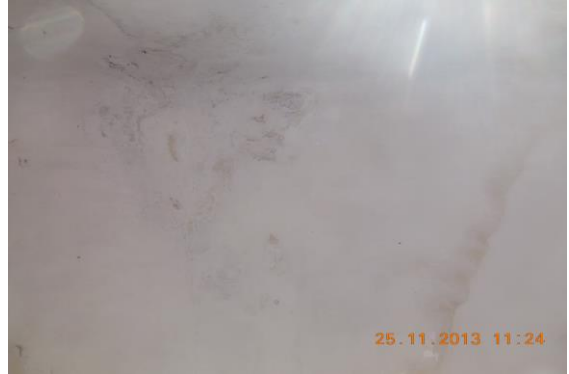
Photo 70

Dampness/Seepage on Roof of Varanda of Shop No.379 of Ground Floor

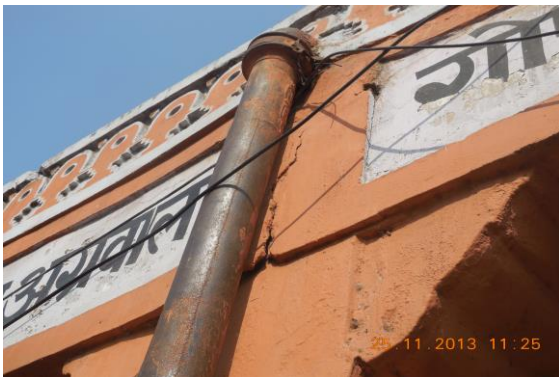
Photo 71

Damaged Portion on Frontside & Left External column of Varanda of Shop No.379 of Ground Floor

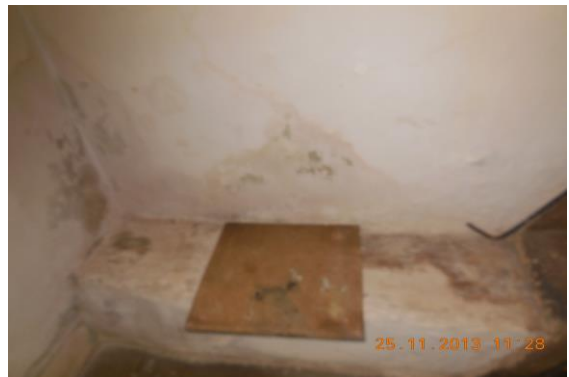
Photo 72

Dampness/Seepage on Wall No. 1 & 4 of Shop No.374 of Ground Floor

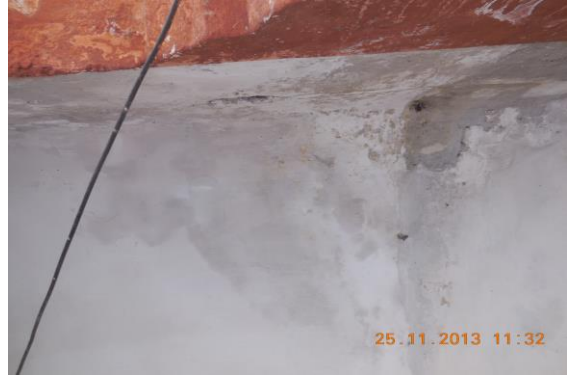
Photo 74

Dampness/Seepage on Roof of Varanda of Shop No.374 of Ground Floor

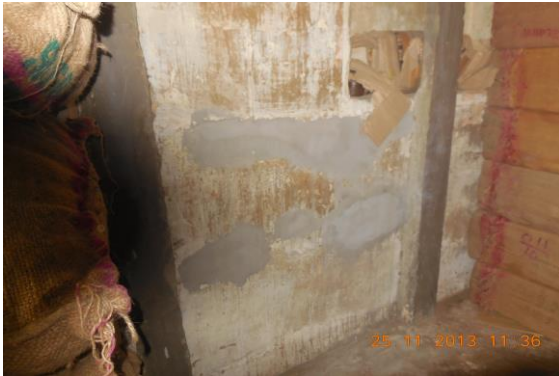
Photo 75

Peeling of Plaster on Wall No. 1 of Shop No.373 of Ground Floor

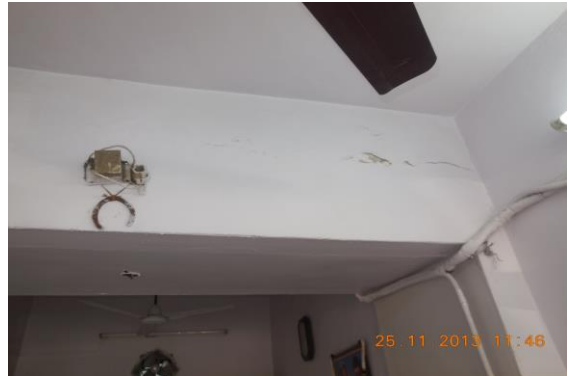
Photo 76

Peeling of Plaster on Roof of Shop No.371 of Ground Floor

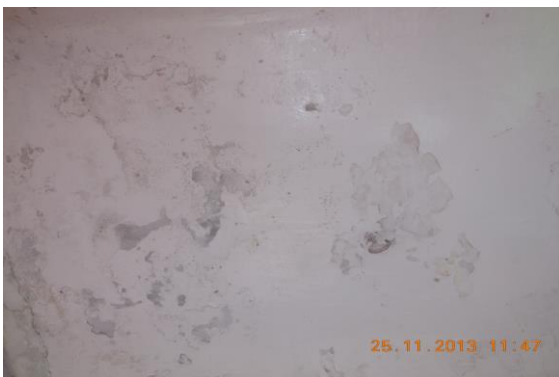
Photo 77

Dampness/Seepage on Roof of Varanda of Shop No.371 of Ground Floor

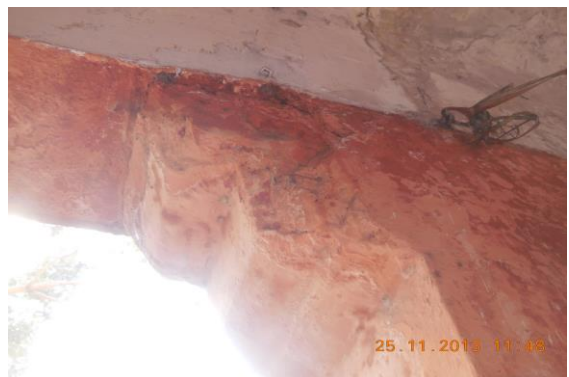
Photo 78

Damaged Portion on Beam of Varanda of Shop No.371 of Ground Floor

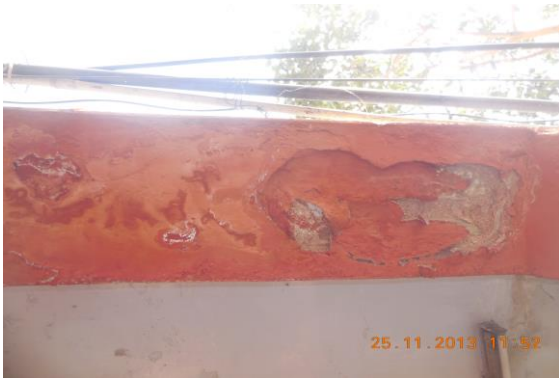
Photo 79

Damaged Portion on Beam of Varanda of Shop No.371 of Ground Floor

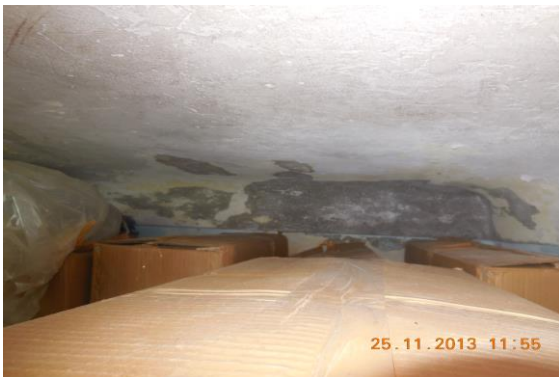
Photo 81

Dampness/Seepage on Wall No. 4 of Shop No.370 of Upper Ground Floor

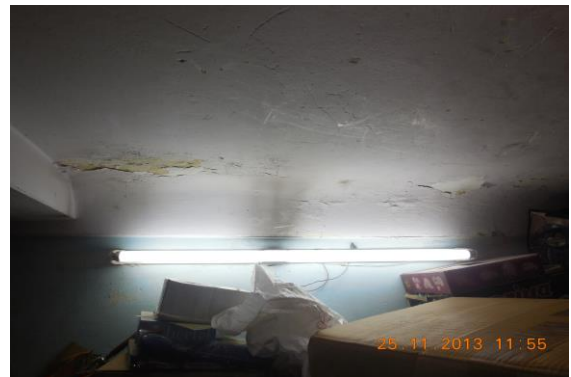
Photo 82

Peeling of Plaster on Roof of Shop No.370 of Upper Ground Floor

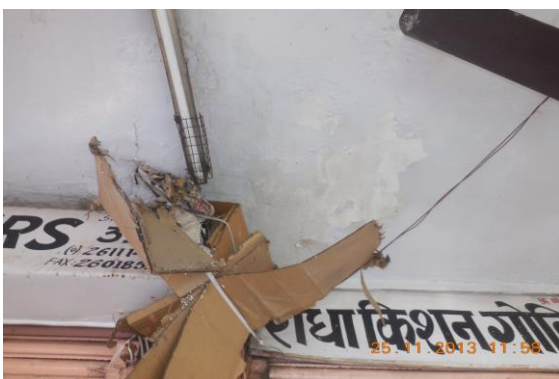
Photo 83

Peeling of Plaster on Roof of Varanda of Shop No.370 of Ground Floor

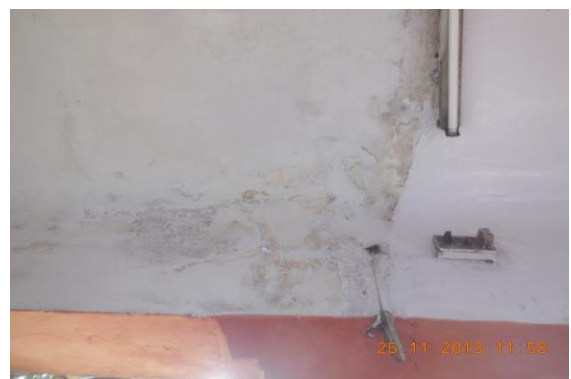
Photo 84

Peeling of Plaster on Roof of Varanda of Shop No.370 of Ground Floor

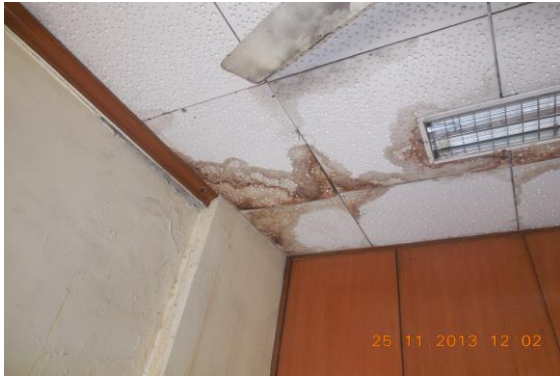
Photo 85  
Dampness/Seepage on Roof of Shop No.377 of Ground Floor

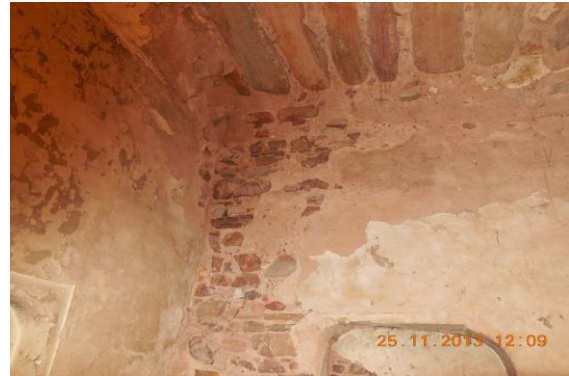
Photo 86  
Damaged Portion on Wall No. 4 of Room No. 1 of Ground Floor

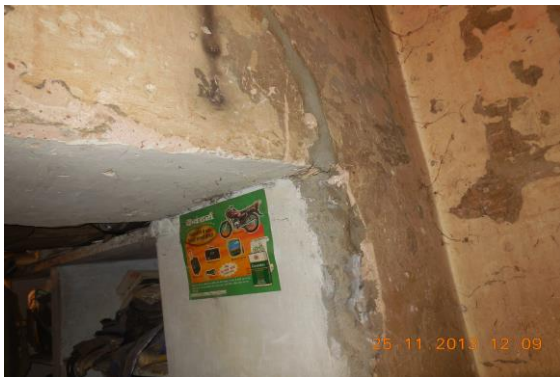
Photo 87  
Damaged Portion on Wall No. 3 of Room No. 1 of Ground Floor

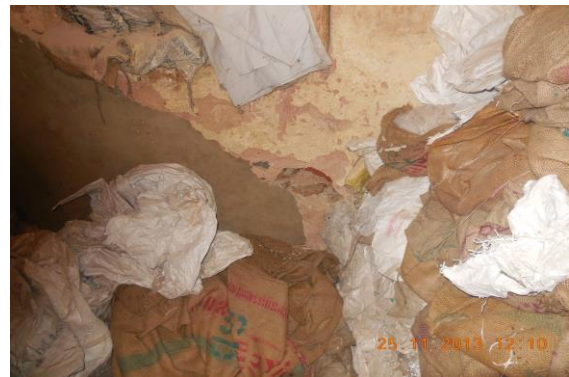
Photo 88  
Damaged Portion on Wall No. 4 of Room No. 1 of Ground Floor

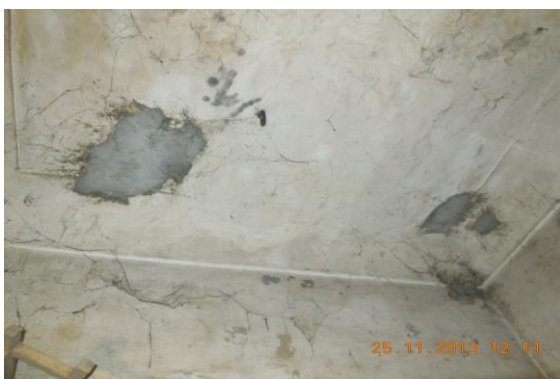
Photo 89  
Peeling of Plaster on Roof of Room No. 2 of Ground Floor

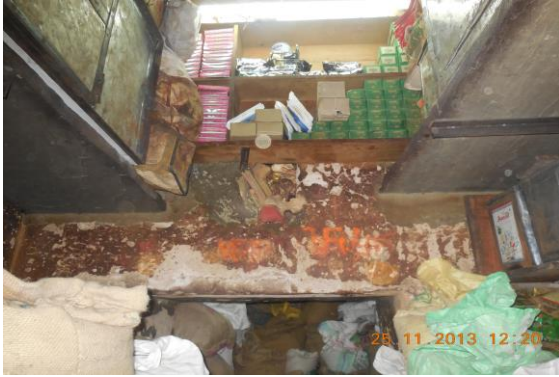
Photo 91

Peeling of Plaster on Wall No. 4 of Room No. 2 of Ground Floor

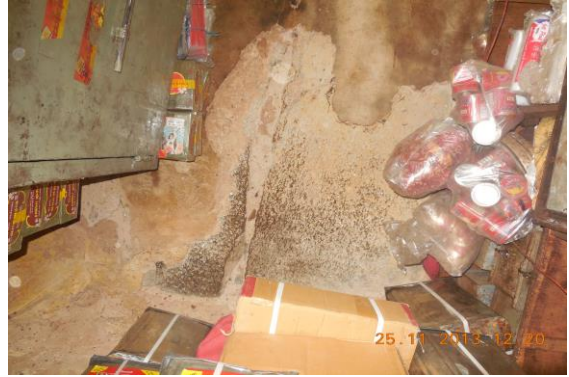
Photo 92

Peeling of Plaster on Roof of Room No. 2 of Ground Floor

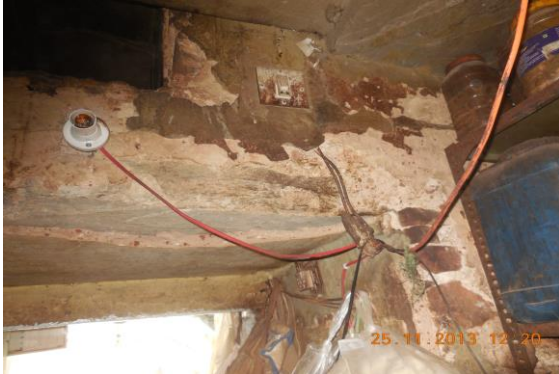
Photo 93

Peeling of Plaster on Wall No. 4 of Room No. 2 of Ground Floor

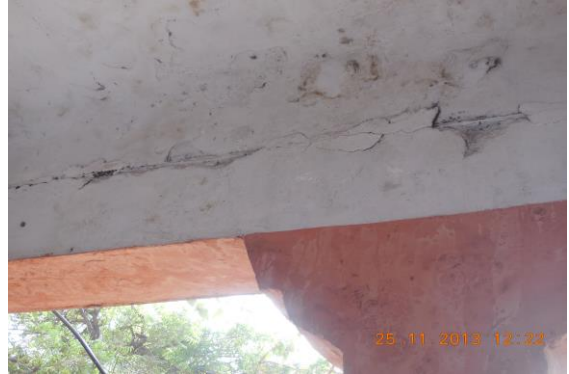
Photo 94

Damaged Portion on Roof of Shop No.367 of Ground Floor

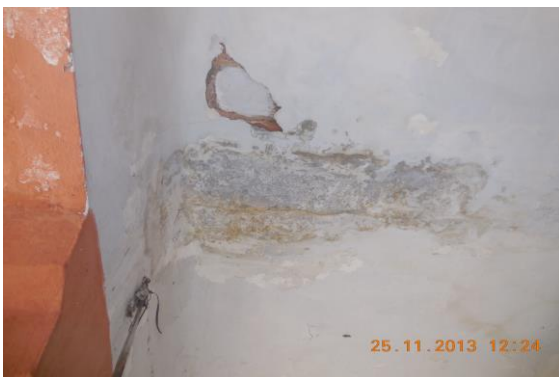
Photo 95

Dampness/Seepage on Roof of Varanda of Shop No.367 of Ground Floor

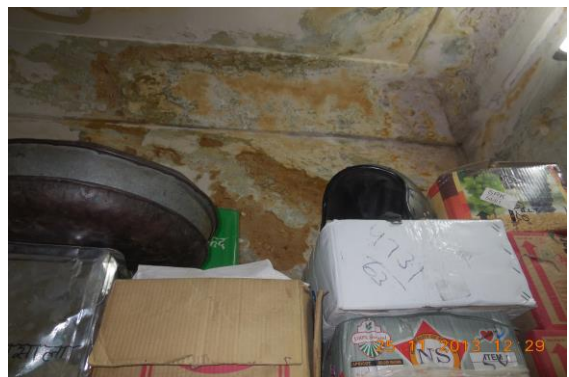
Photo 96

Dampness/Seepage on Wall No. 2 & Roof of Room No. 2 of Ground Floor

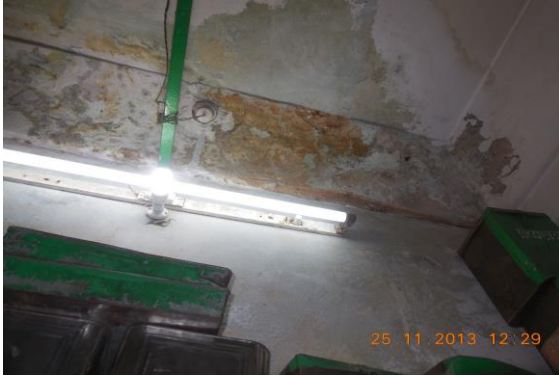
Photo 97  
Peeling of Plaster on Roof of Room No. 2 of Ground Floor

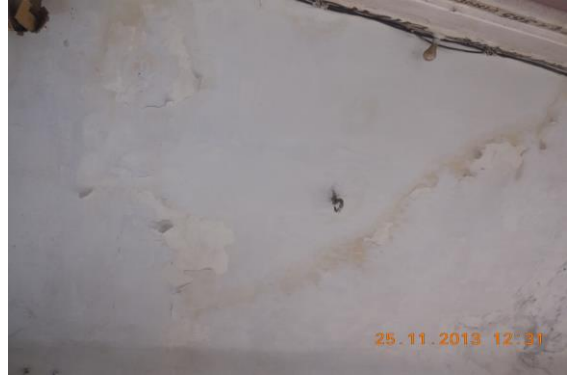
Photo 98  
Dampness/Seepage on Roof of Varanda of Shop No.365 of Ground Floor

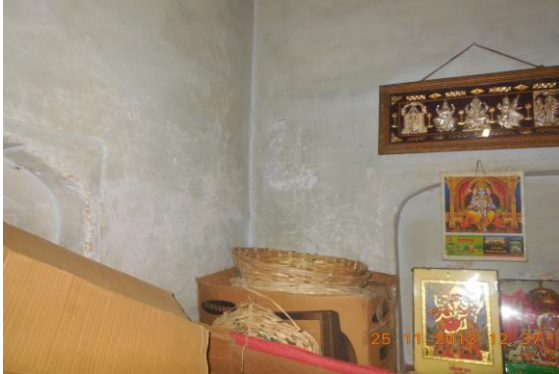
Photo 99  
Dampness/Seepage on Wall No. 4 & 1 of Room No. 1 of Ground Floor

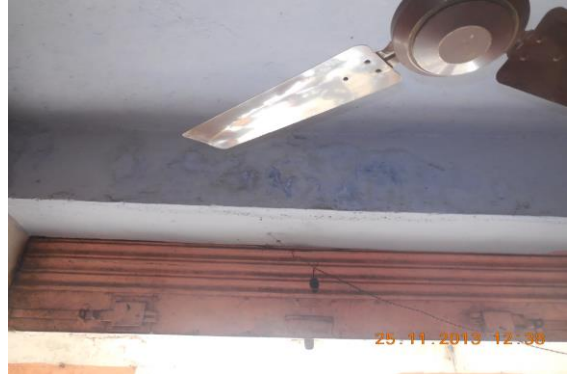
Photo 100  
Dampness/Seepage on Wall No. 3 of Shop No.366 of Ground Floor

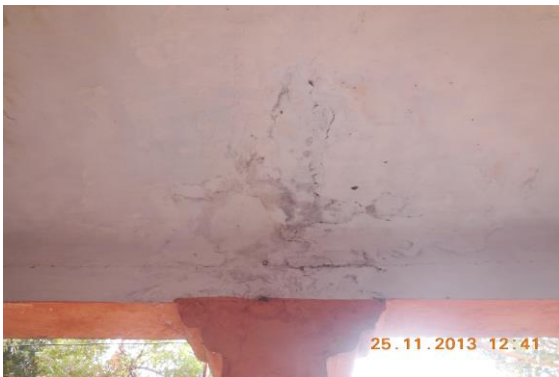
Photo 101  
Dampness/Seepage on Roof of Varanda of Shop No.366 of Ground Floor

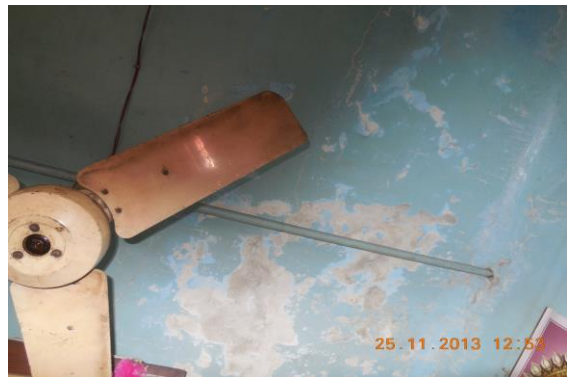
Photo 102  
Dampness/Seepage on Roof & 4 of Shop No.363 of Ground Floor

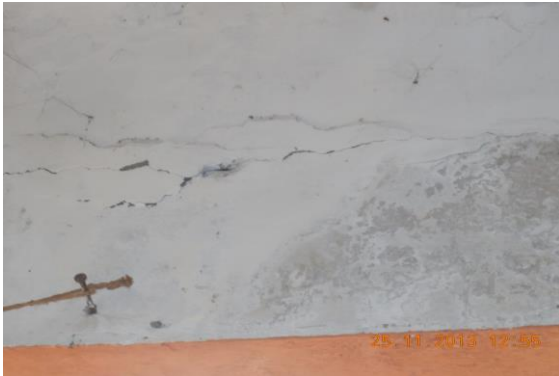
Photo 103

Damaged Portion on Roof of Varanda of Shop No.363 of Ground Floor

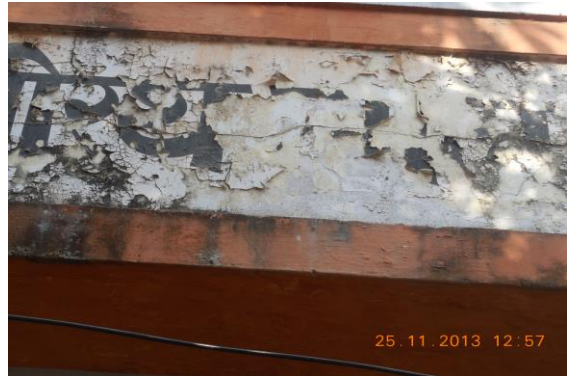
Photo 104

Damaged Portion on Roof of Varanda of Shop No.363 of Ground Floor

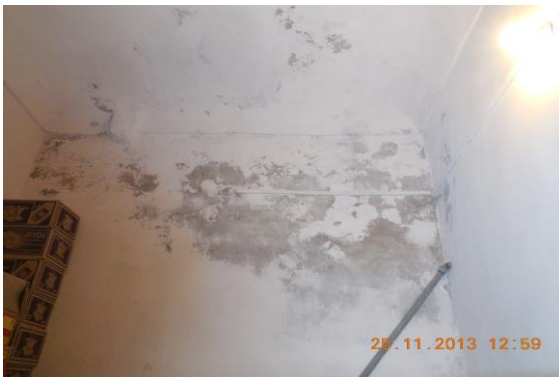
Photo 105

Dampness/Seepage on Wall No. 4 & Roof of Shop No.362 of Ground Floor

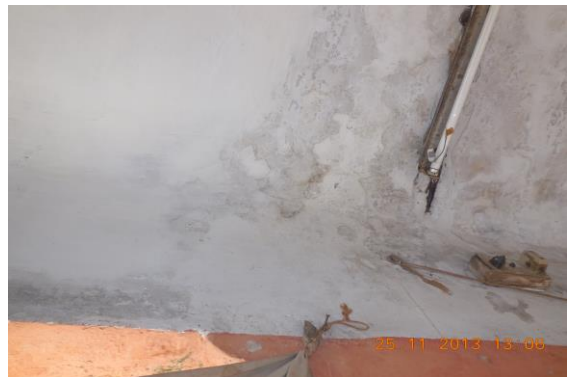
Photo 106

Dampness/Seepage on Roof of Varanda of Shop No.361 of Ground Floor

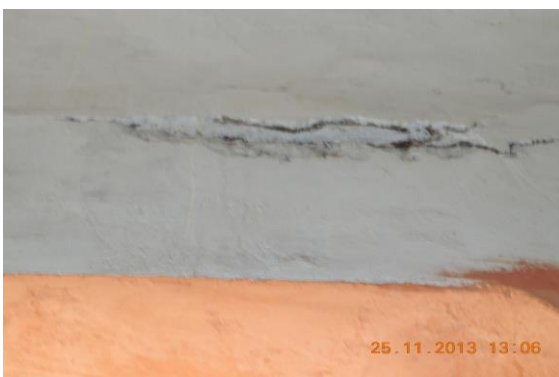
Photo 107

Damaged Portion on Roof of Varanda of Shop No.362 of Ground Floor

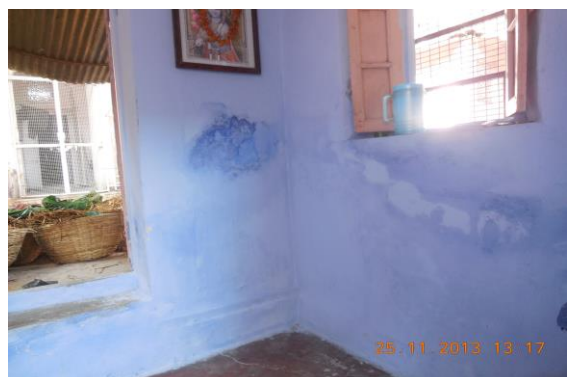
Photo 108

Dampness/Seepage on Wall No. 2 & 4 of Shop Rajesh Chand Sharma of Ground Floor

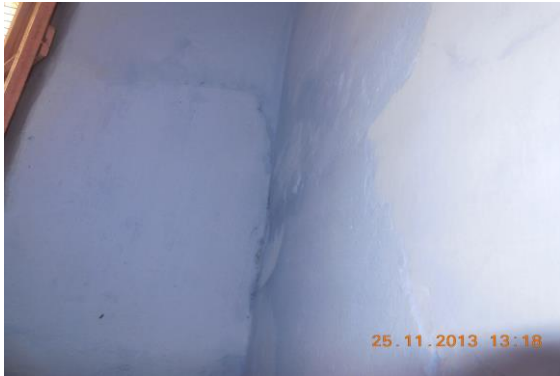
Photo 109

Dampness/Seepage on Wall No. 3 of Shop Rajesh Chand Sharma of Ground Floor

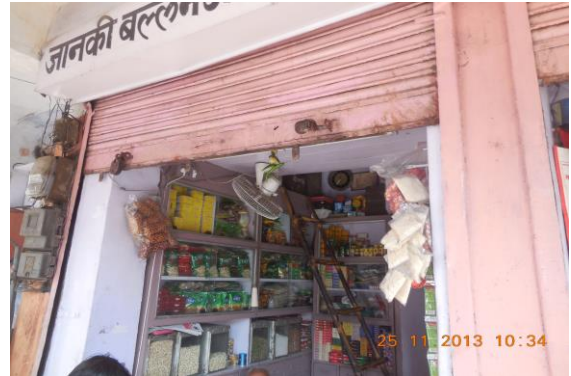
Photo 110

All Walls of Shop No.381 of Ground Floor Covered With Wooden Work

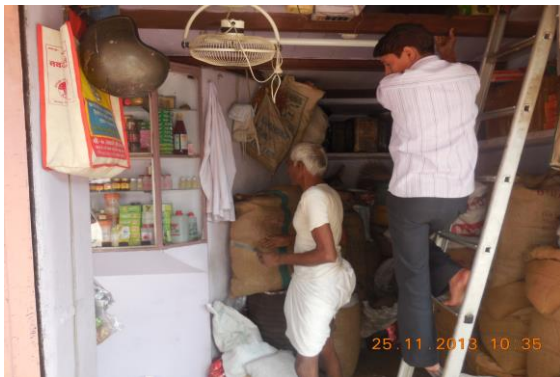
Photo 111

All Walls of Shop No.380 of Ground Floor Covered With Wooden Work

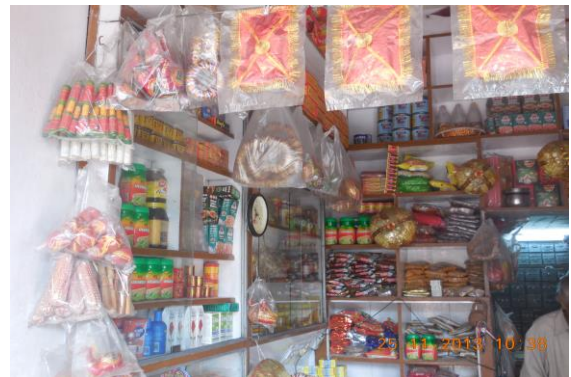
Photo 112

Wall No. 1 & 4 of Shop No.378 of Ground Floor Covered With Wooden Rack

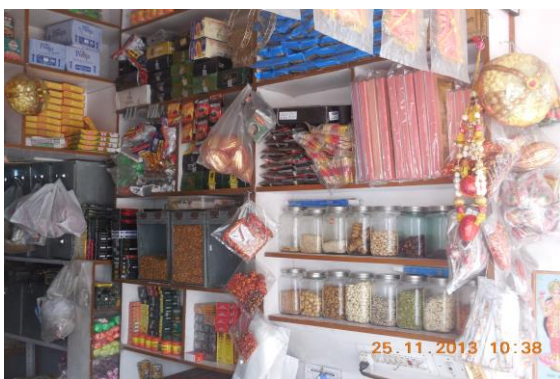
Photo 113

Wall No. 2 & 4 of Shop No.378 of Ground Floor Covered With Wooden Rack

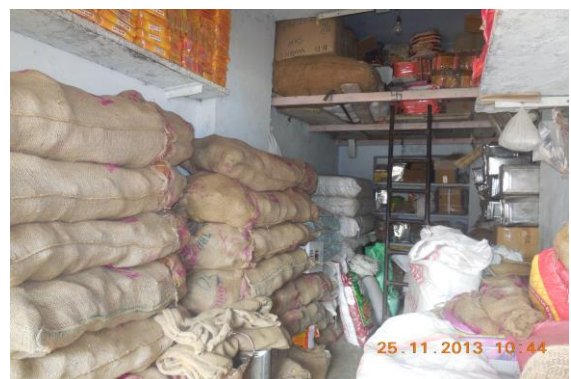
Photo 114

Wall No. 1 & 4 of Shop No.376 of Ground Floor Covered With Wooden Rack

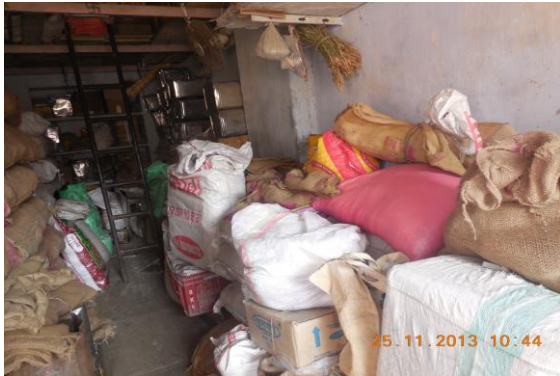
Photo 115

Wall No. 2 & 4 of Shop No.376 of Ground Floor Covered With Wooden Rack

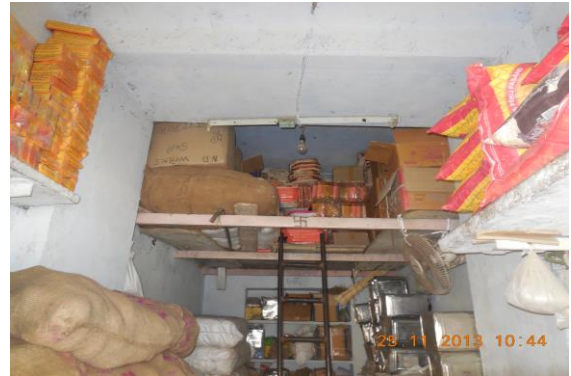
Photo 116

Roof of Shop No.376 of Ground Floor Covered With Wooden Work

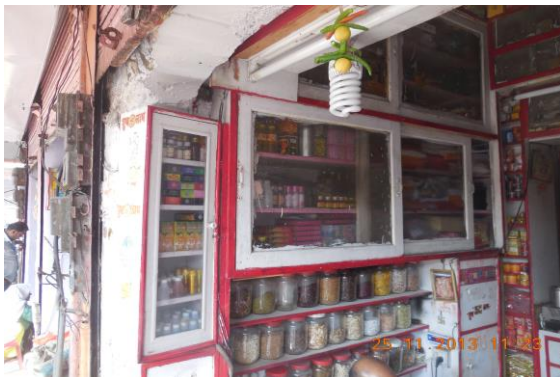
Photo 117

Wall No. 1 of Shop No.379 of Ground Floor Covered With wooden Works & Material

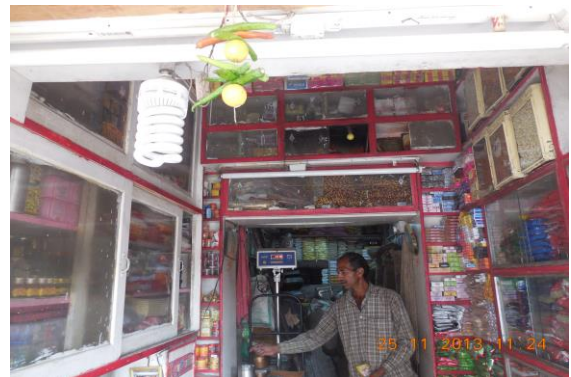
Photo 118

Wall No. 4 of Shop No.379 of Ground Floor Covered With wooden Works & Material

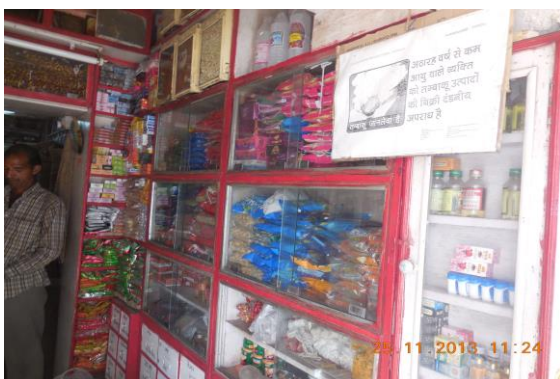
Photo 119

Wall No. 2 of Shop No.379 of Ground Floor Covered With wooden Works & Material

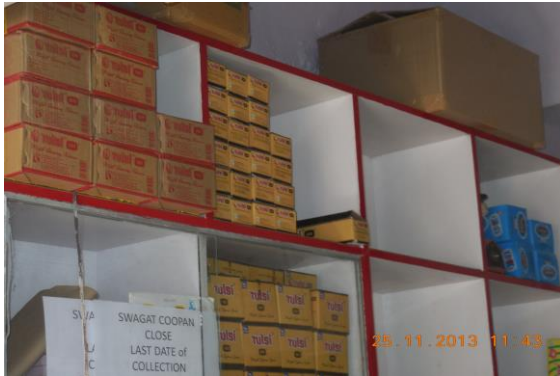
Photo 121

Wall No. 1 of Shop No.373 of Ground Floor Covered With Wooden Rack

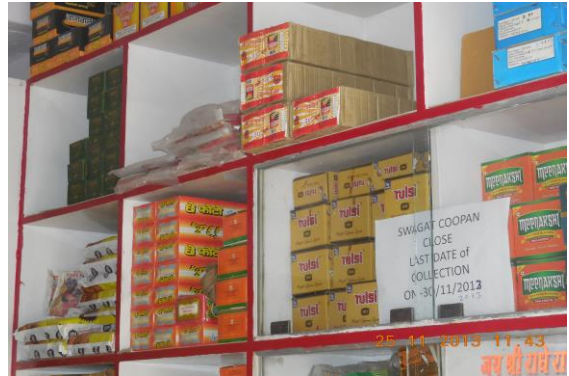
Photo 122

Wall No. 2 of Shop No.373 of Ground Floor Covered With Wooden Rack

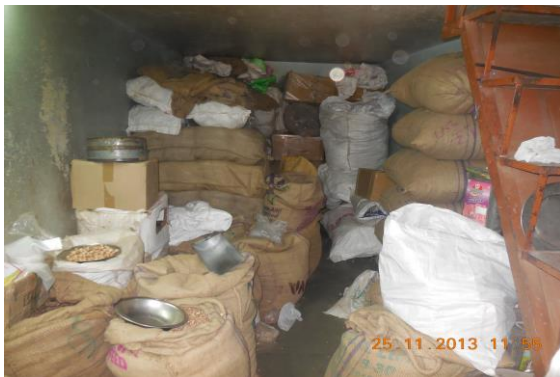
Photo 123

All Walls of Shop No.370 of Ground Floor Covered With Material
