### Pre Building Condition Survey Report

Name and Address of Structure :	Badi Chopar to Ramp Area (UP Line)
---------------------------------	------------------------------------

Name of the Project	<b>Contract JMRC-UG1B</b> “Design and Construction of Tunnel between Chandpole and Badi Chouper and reverse line by Shield TBM, Underground Metro Stations at Choti Chouper and Badi Chouper by Cut and Cover Methods on East West Corridor of Jaipur Metro Rail Corporation Limited .”	
Owner :

Pre Building Condition Survey Report Badi Chopar to Ramp Area (UP Line)

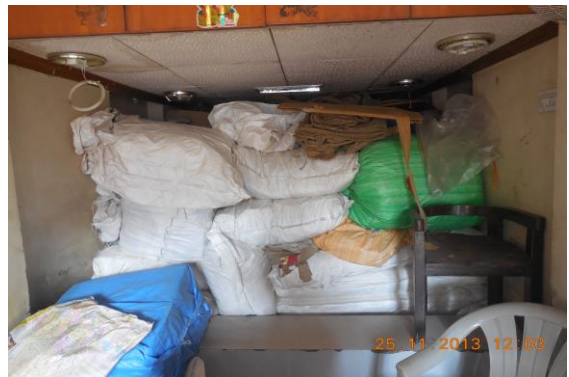
Photo 124

Wall No. 4 of Shop No.377 of Ground Floor Covered With Material

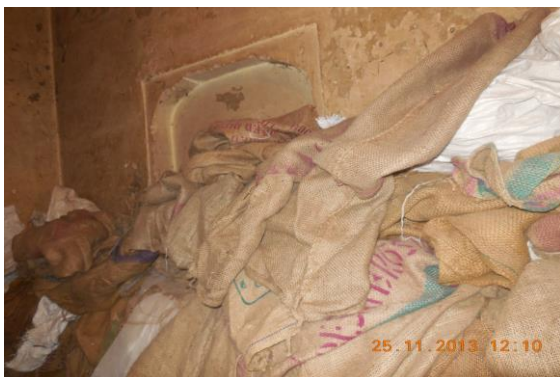
Photo 125

Wall No. 2 of Room No. 1 of Ground Floor Covered With Beg

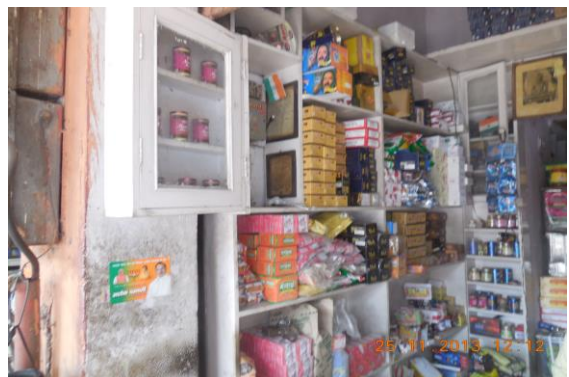
Photo 126

Wall No. 1 of Shop No.369 of Ground Floor Covered With Wooden Work

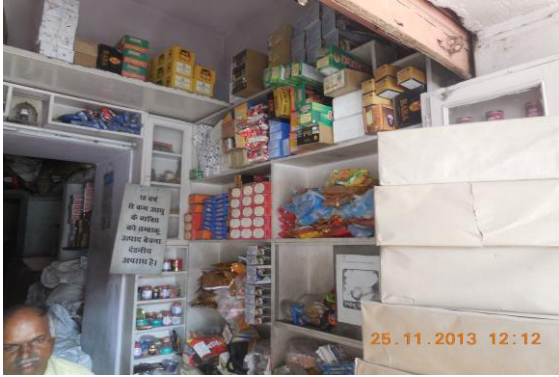
Photo 127

Wall No. 2 of Shop No.369 of Ground Floor Covered With Wooden Work

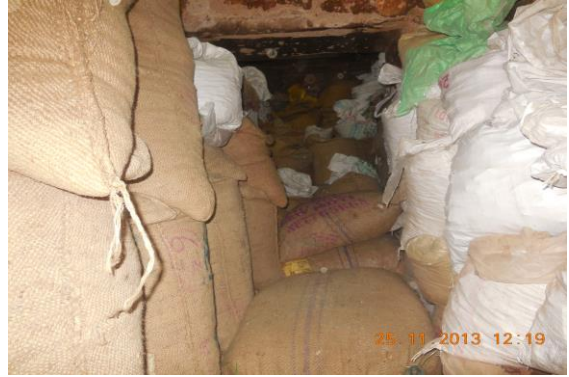
Photo 128

Wall No. 1 & 2 of Room No. 2 of Ground Floor Covered With Material

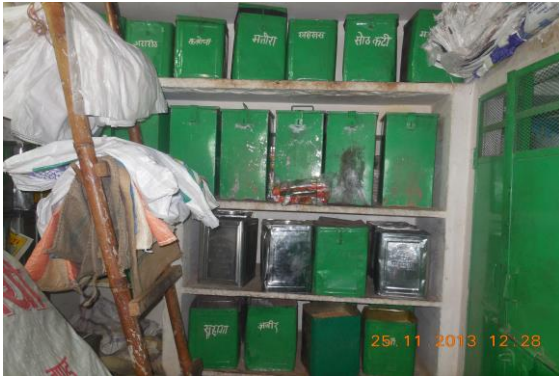
Photo 129

Wall No. 4 of Room No. 1 of Ground Floor Covered With Material

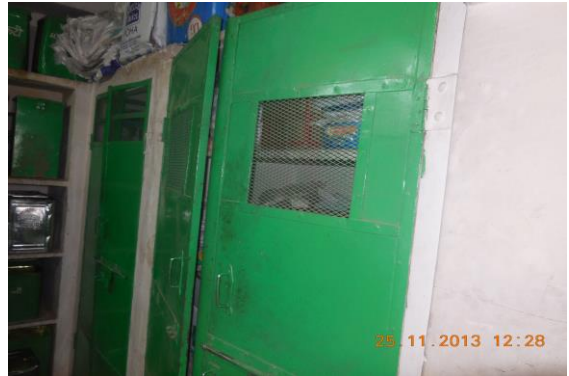
Photo 130

Wall No. 2 of Room No. 1 of Ground Floor Covered With Material & Almira

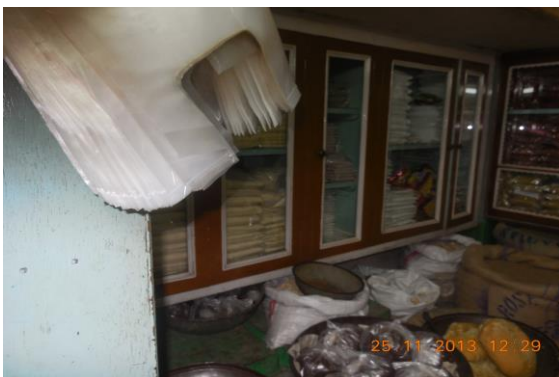
Photo 131

Wall No. 1 of Room No. 2 of Ground Floor Covered With Material

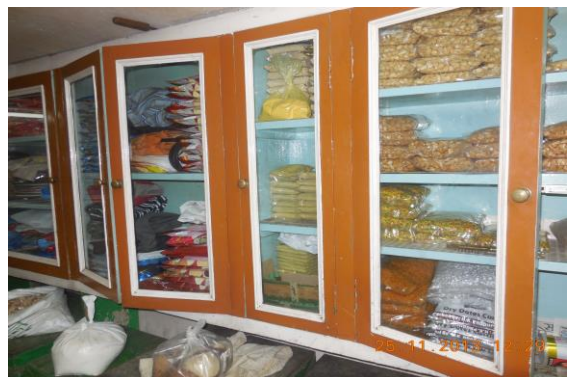
Photo 132

Wall No. 2 & 4 of Room No. 2 of Ground Floor Covered With Material

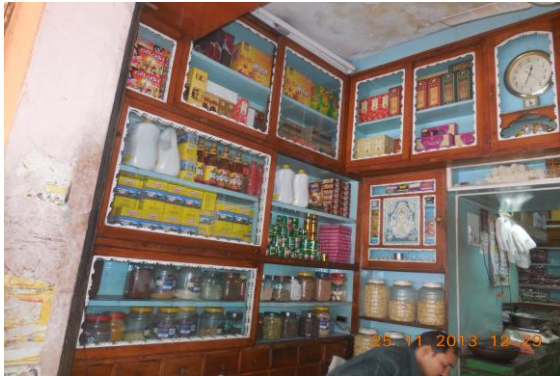
Photo 133

Wall No. 1 of Varanda of Shop No.365 of Ground Floor Covered With Material

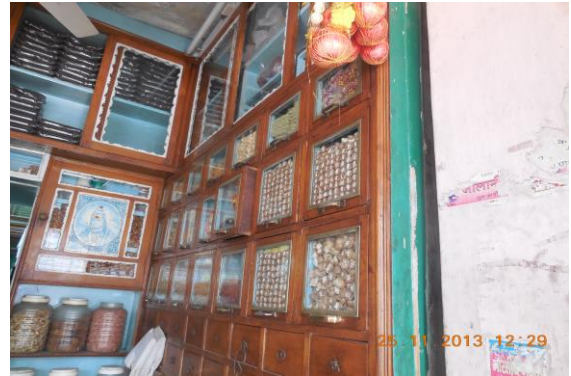
Photo 134

Wall No. 2 & 4 of Varanda of Shop No.365 of Ground Floor Covered With Material

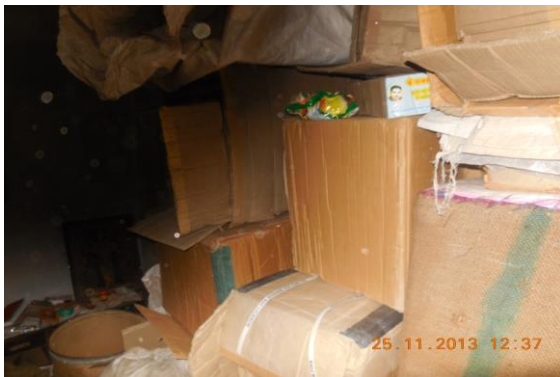
Photo 135

Wall No. 2 of Room No. 1 of Ground Floor Covered With Material

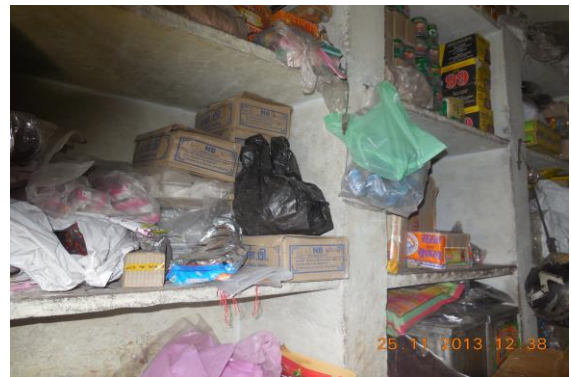
Photo 136

Wall No. 1 of Room No. 2 of Ground Floor Covered With Material

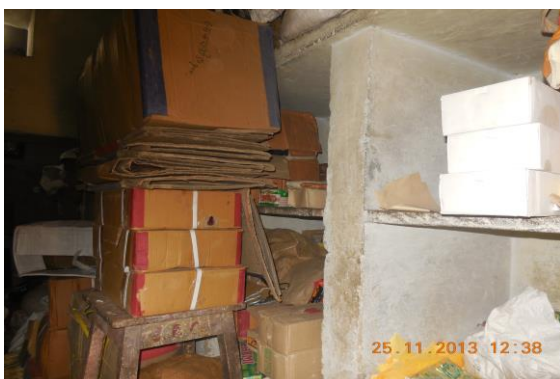
Photo 137

Wall No. 2 of Room No. 2 of Ground Floor Covered With Material

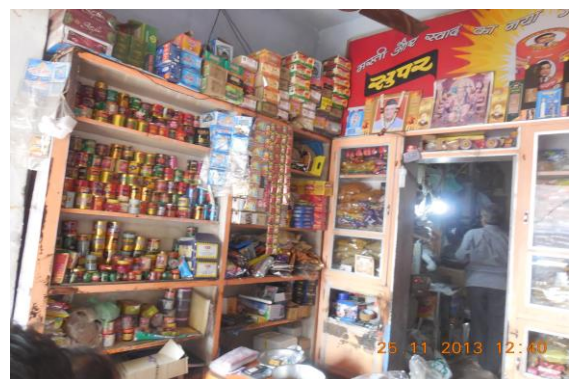
Photo 138

Wall No. 1 & 4 of Shop No.366 of Ground Floor Covered With Material

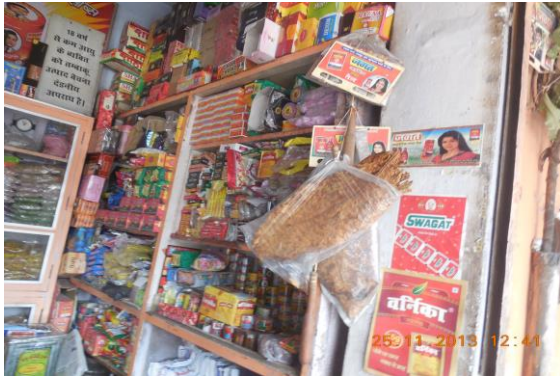
Photo 139

Wall No. 2 of Shop No.366 of Ground Floor Covered With Material

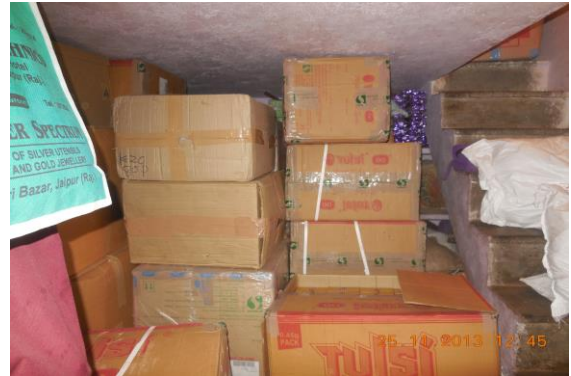
Photo 140

Wall No. 4 of Room No. 1 of Ground Floor Covered With Material

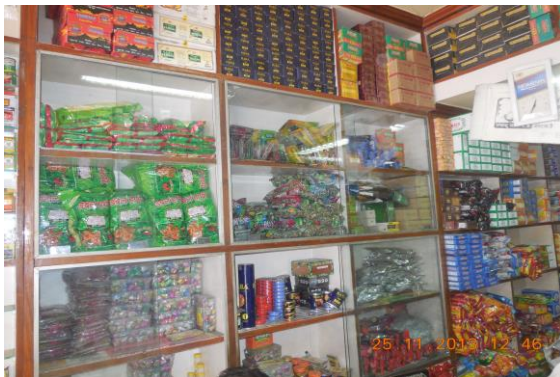
Photo 141

Wall No. 1 of Shop No.364 of Ground Floor Covered With Material

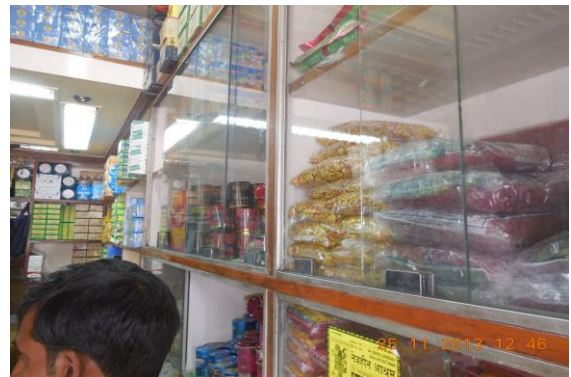
Photo 142

Wall No. 2 of Shop No.364 of Ground Floor Covered With Material

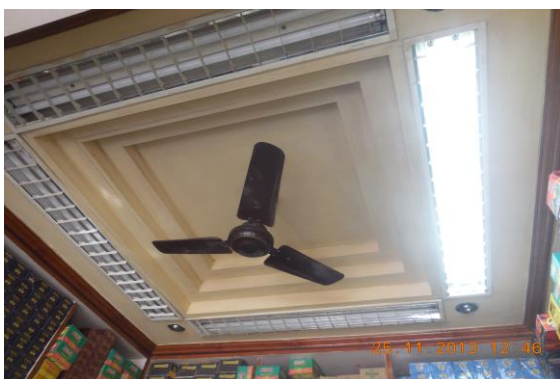
Photo 143

Roof of Shop No.364 of Ground Floor Covered With Falls Ceiling

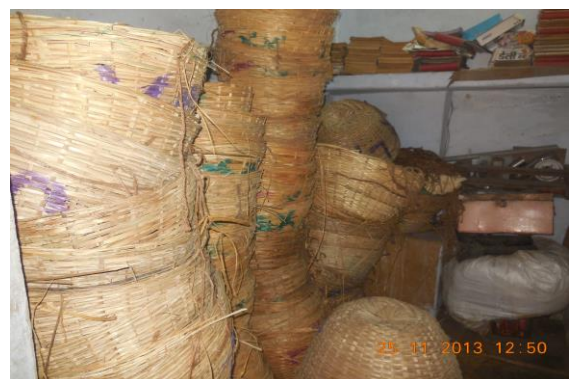
Photo 144

Wall No. 1 of Room No. 1 of Ground Floor Covered With Material

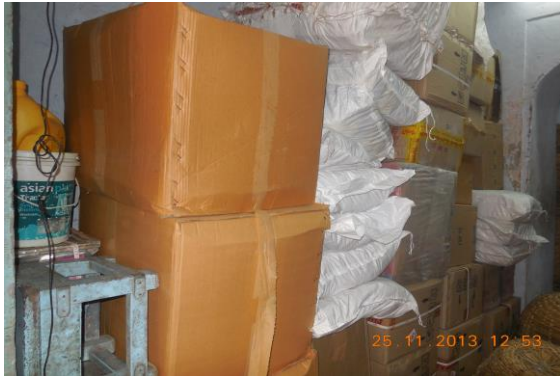
Photo 145

Wall No. 1 of Room No. 2 of Ground Floor Covered With Material

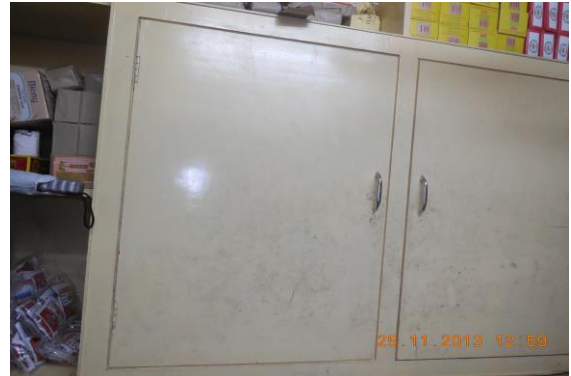
Photo 146

Wall No. 1 of Shop No.362 of Ground Floor Covered With Wooden Work

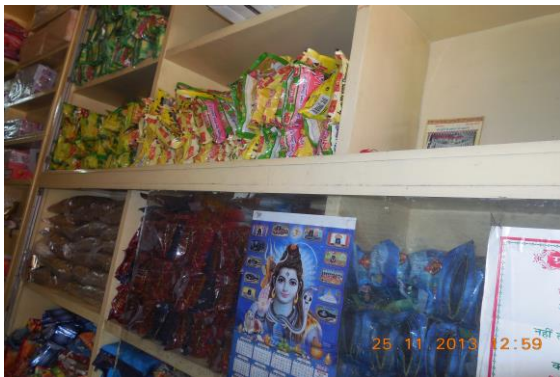
Photo 147

Wall No. 1 of Shop No.362 of Ground Floor Covered With Wooden Work

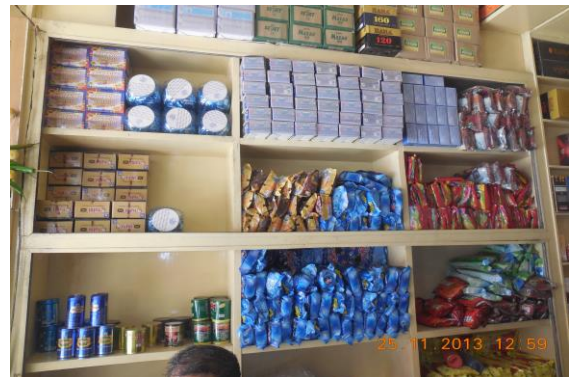
Photo 148

Wall No. 2 of Shop No.362 of Ground Floor Covered With Wooden Work

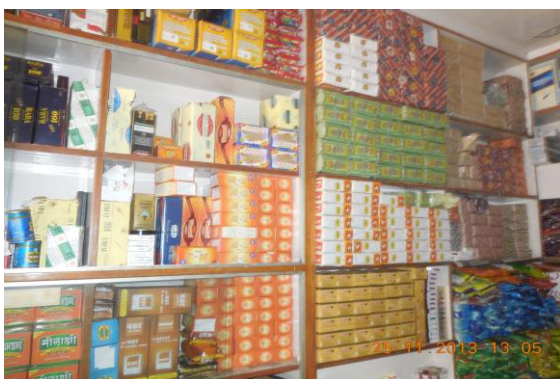
Photo 149

Wall No. 1 of Shop No.361 of Ground Floor Covered With Wooden Work

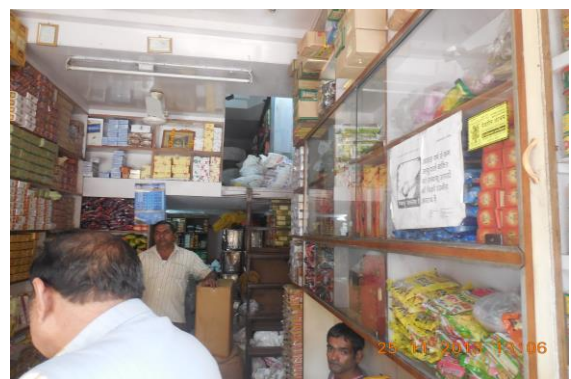
Photo 150

Wall No. 2 & 4 of Shop No.361 of Ground Floor Covered With Wooden Work

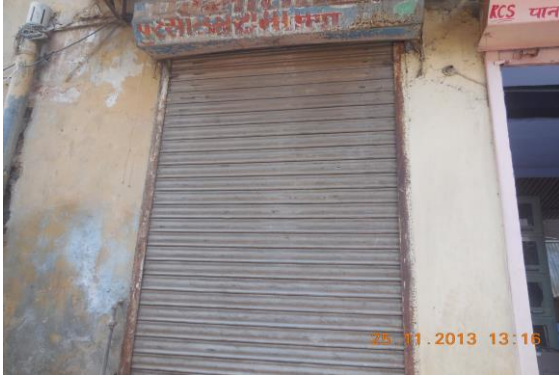
Photo 151  
Shop No.360A of Ground Floor Locked

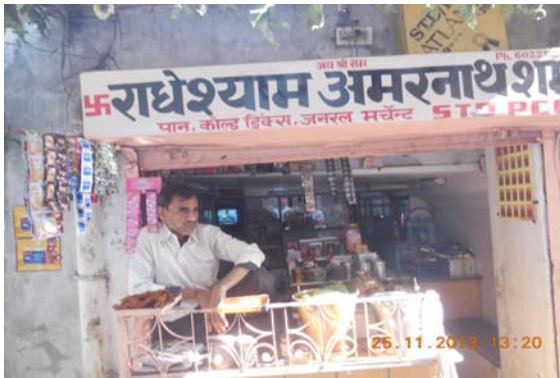
Photo 1  
View of Shop Radheshyam Amarnath

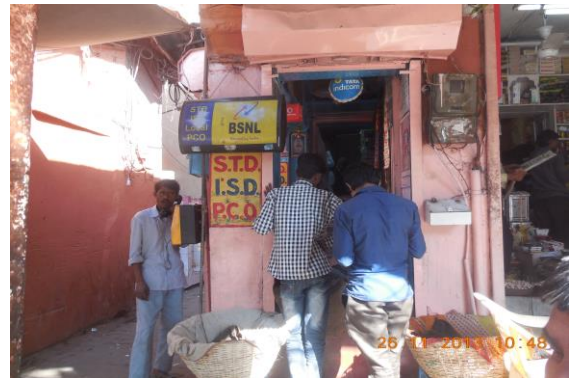
Photo 2  
View of Shop No.360, Ground Floor

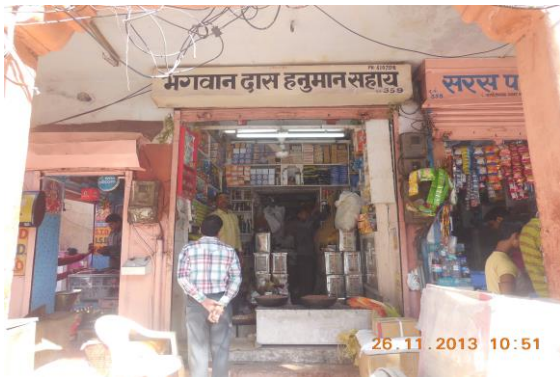
Photo 3  
View of Shop No.359, Ground Floor

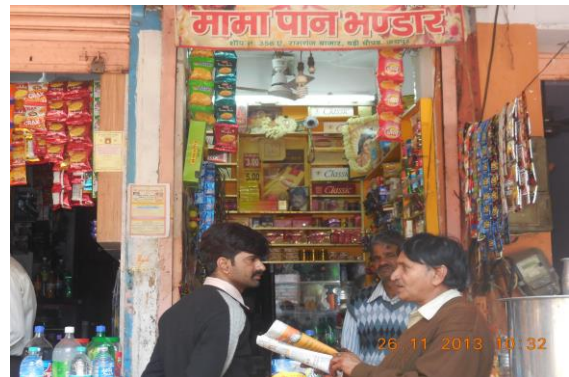
Photo 4  
Shop No.358A, Ground Floor

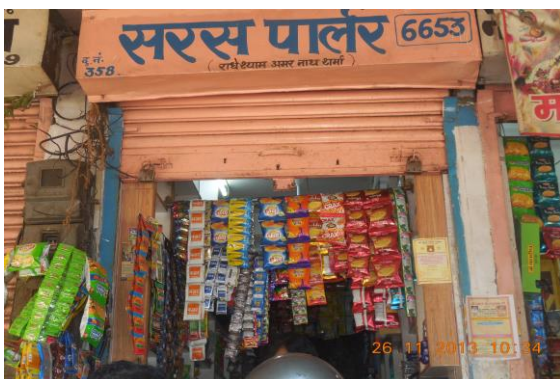
Photo 5  
Shop No.358, Ground Floor

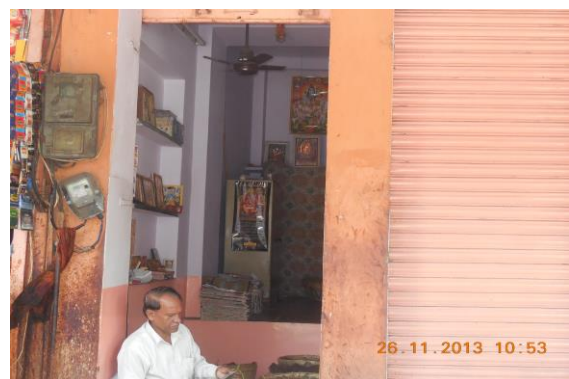
Photo 6  
Shop No.357, Ground Floor

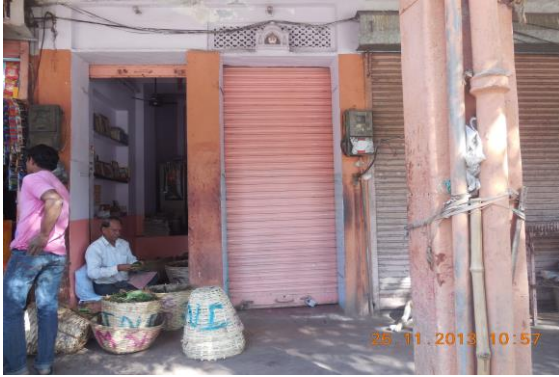
Photo 7  
View of Shop No.357, Ground Floor

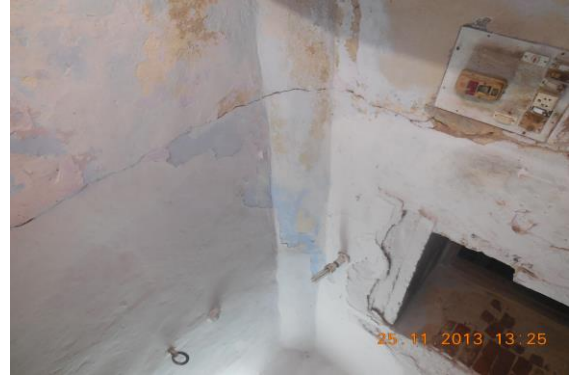
Photo 8  
Horizontal Crack on Roof of Room No. 1, Shop Kailash Chand Sharma, Ground Floor Approx. Width = 10mm, Approx. Length = 2.3m. Distance from Wall No.2 = 0m, Height from Floor = 1.5m.

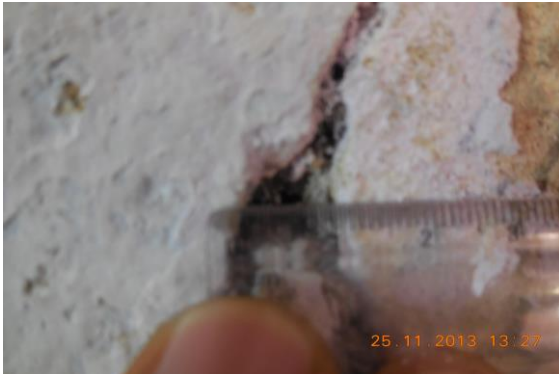
Photo 8A  
Horizontal Crack on Roof of Room No. 1, Shop Kailash Chand Sharma, Ground Floor Approx. Width = 10mm, Approx. Length = 2.3m. Distance from Wall No.2 = 0m, Height from Floor = 1.5m.

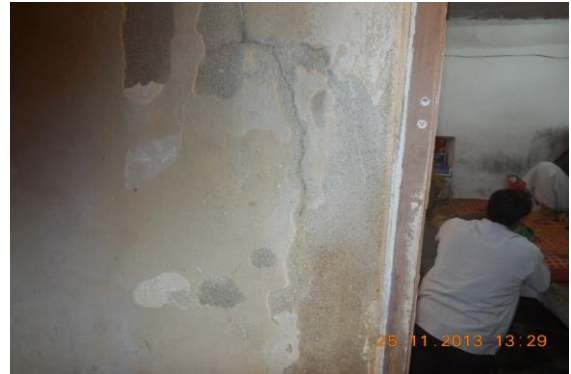
Photo 9  
Inclined Crack on Wall No. 3 of Room No. 2, Shop Kailash Chand Sharma, Ground Floor Approx. Width = 0.5mm, Approx. Length = 1.5m. Distance from Wall No.1 = 1m, Height from Floor = 0m.

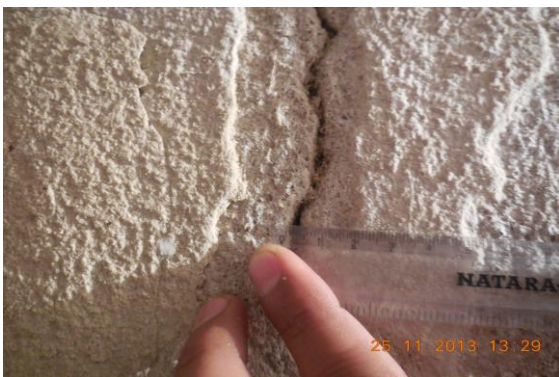
Photo 9A  
Inclined Crack on Wall No. 3 of Room No. 2, Shop Kailash Chand Sharma, Ground Floor Approx. Width = 0.5mm, Approx. Length = 1.5m. Distance from Wall No.1 = 1m, Height from Floor = 0m.

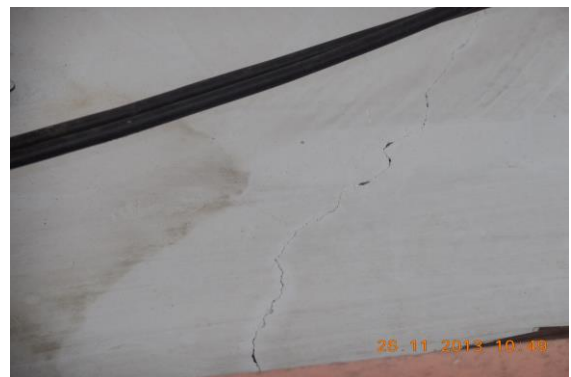
Photo 10  
Inclined Crack on Outer Wall of Shop No.360, Ground Floor Approx. Width = 0.2mm, Approx. Length = 3m. Distance from Internal Leftside Beam = 0.7m, Height from Floor = 3m.

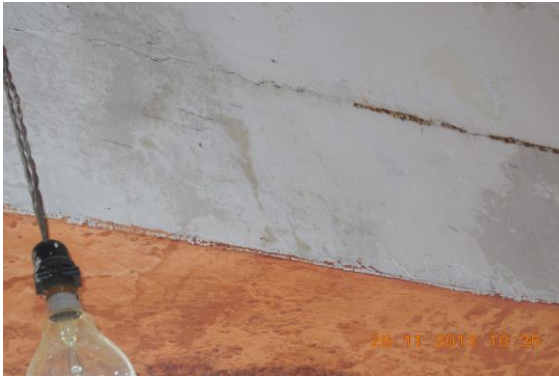
Photo 11

Horizontal Crack on External Beam of Varanda of Shop No.358, Ground Floor Approx. Width = 5mm, Approx. Length = 3m. Distance from Leftside External Beam = m, Height from Floor = m.

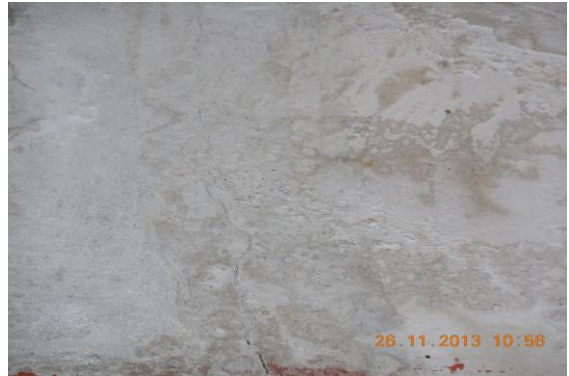
Photo 12

Inclined Crack on Beam of Shop No.357, Ground Floor Approx. Width = 0.15mm, Approx. Length = 0.5m. Distance from Leftside External Beam = 0m, Height from Floor = 2.5m.

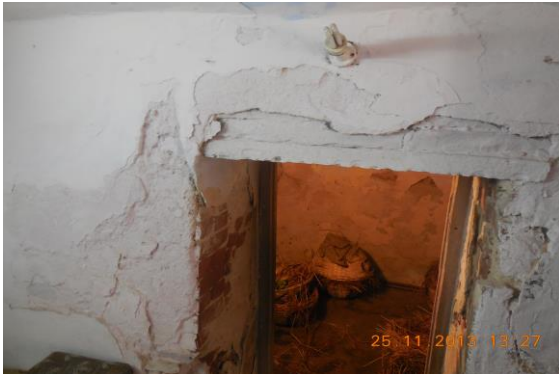
Photo 13

Damaged Portion on Wall No. 2 of Room No. 1 of Shop Kailash Chand Sharma, Ground Floor

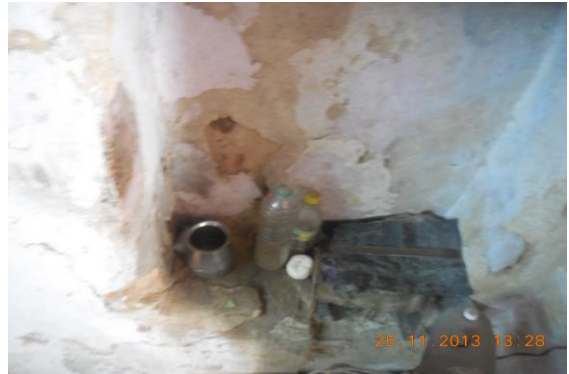
Photo 14

Damaged Portion on Wall No. 2 of Room No. 1 of Shop Kailash Chand Sharma, Ground Floor

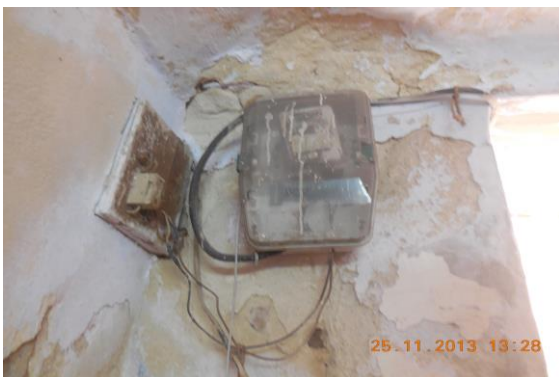
Photo 15

Damaged Portion on Wall No. 3 of Room No. 1 of Shop Kailash Chand Sharma, Ground Floor

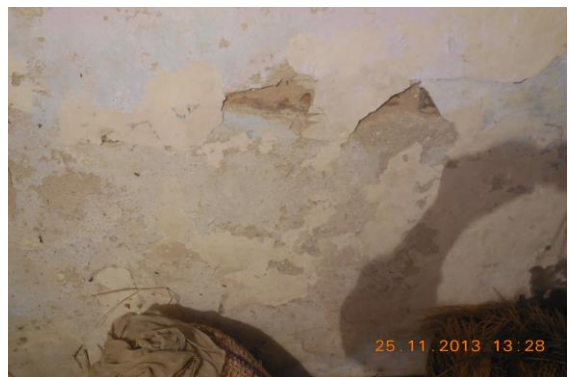
Photo 16

Damaged Portion on Wall No. 4 of Room No. 2 of Shop Kailash Chand Sharma, Ground Floor

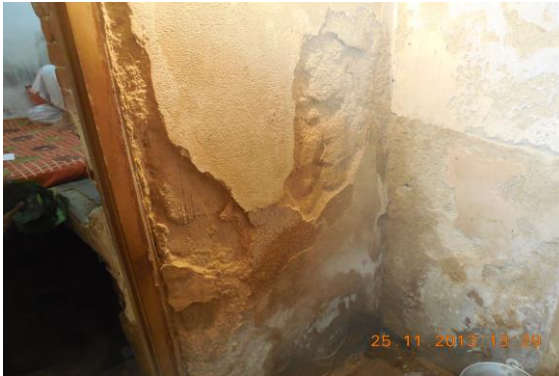
Photo 17

Damaged Portion on Wall No. 3 of Room No. 2 of Shop Kailash Chand Sharma, Ground Floor

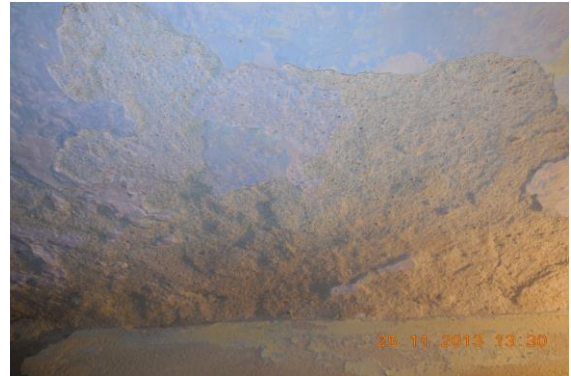
Photo 18

Damaged Portion on Roof of Room No. 2 of Shop Kailash Chand Sharma, Ground Floor

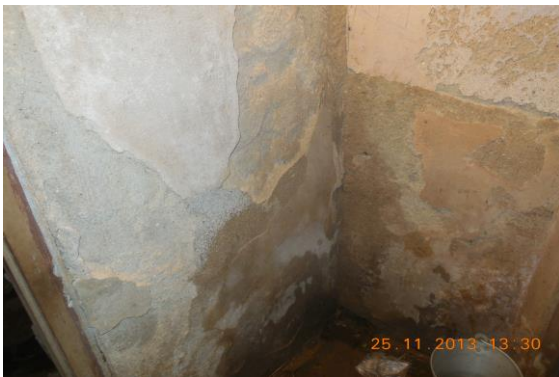
Photo 19

Damaged Portion on Wall No. 1 of Room No. 2 of Shop Kailash Chand Sharma, Ground Floor

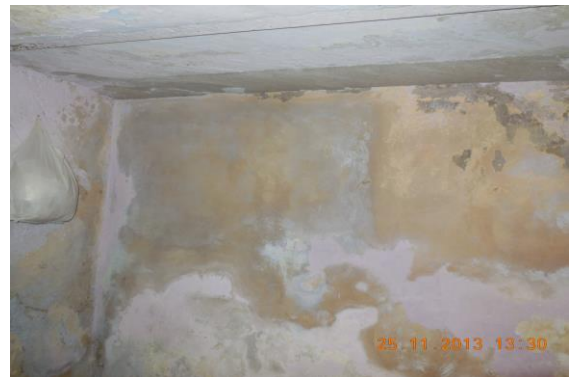
Photo 20

Dampness/Seepage on Wall No. 2 of Room No. 2 of Shop Kailash Chand Sharma, Ground Floor

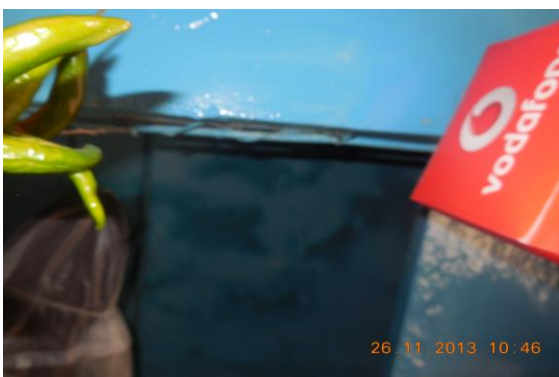
Photo 21

Dampness/Seepage on Roof of Shop No.360 of Ground Floor

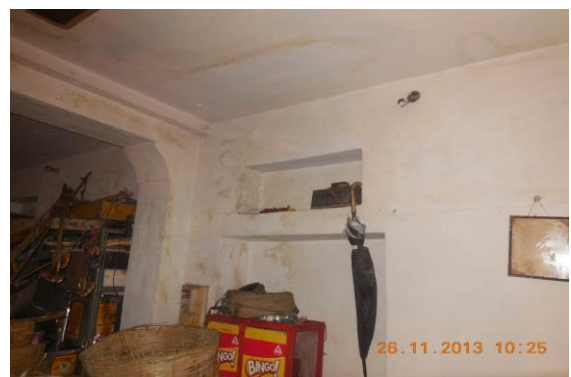
Photo 22

Dampness/Seepage on Wall No. 4 of Shop No.358A of First Floor

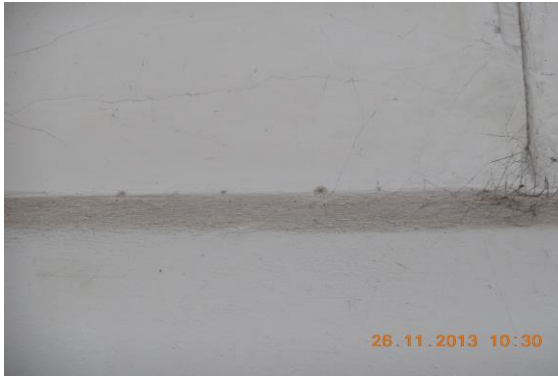
Photo 23  
Peeling of Plaster on Roof of Shop No.358A of Ground Floor

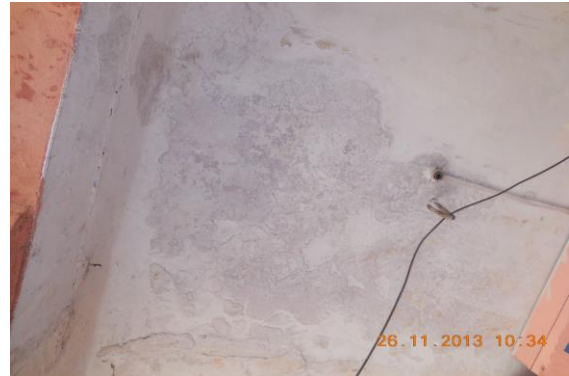
Photo 24  
Dampness/Seepage on Roof of Varanda of Shop No.358 of Ground Floor

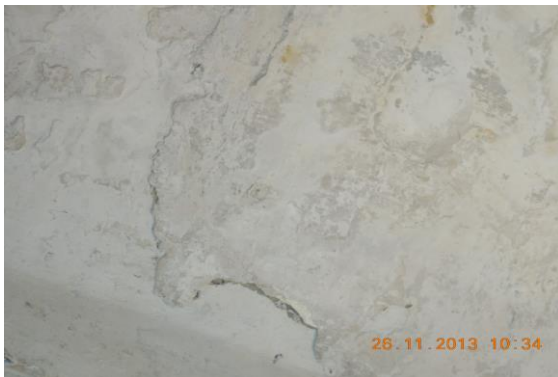
Photo 25  
Peeling of Plaster on Beam of Varanda of Shop No.358 of Ground Floor

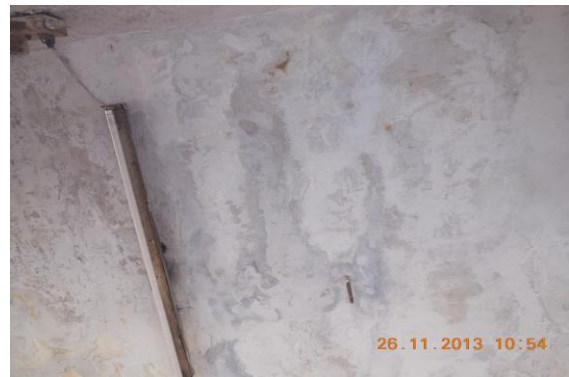
Photo 26  
Dampness/Seepage on Varanda of Shop No.357 of Ground Floor

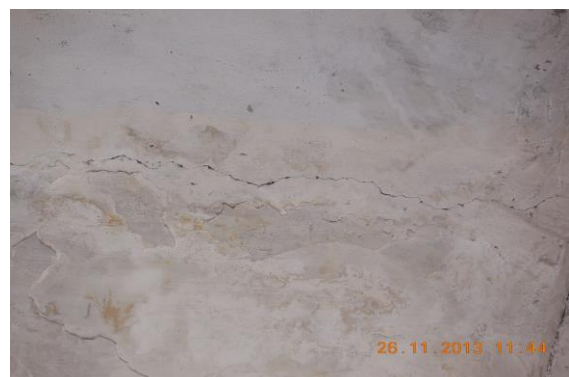
Photo 12  
Inclined Crack on Roof of Varanda of Shop No.350, Ground Floor  
Approx. Width = 0.8mm, Approx. Length = 2m.Distance from Rightside External Column = 0m, Height from Floor = 3.5m.

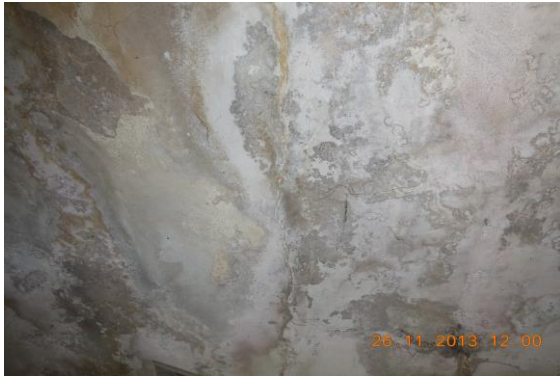
Photo 13

Horizontal Crack on Wall No. 3 & Roof of Part C of Shop No.351, Ground Floor

Approx. Width = 1mm, Approx. Length = 2.5m.

Distance from Wall No 2 = 1.3m Height from Floor = 2m

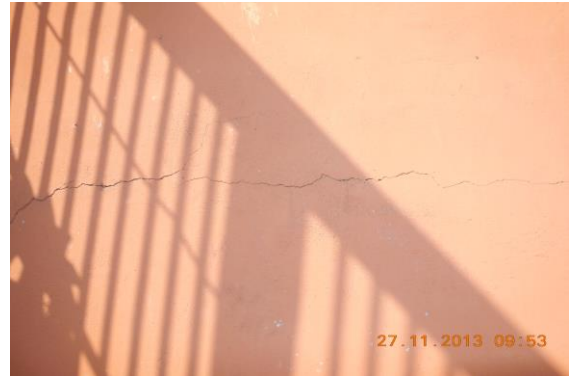
Photo 14

Horizontal Crack on Wall No. 1 of Stair GF to FF, First Floor, Approx.

Width = 1.5mm, Approx. Length = 1.6m.

Distance from w3 = 0.2m, Height from Floor = 1.4m.

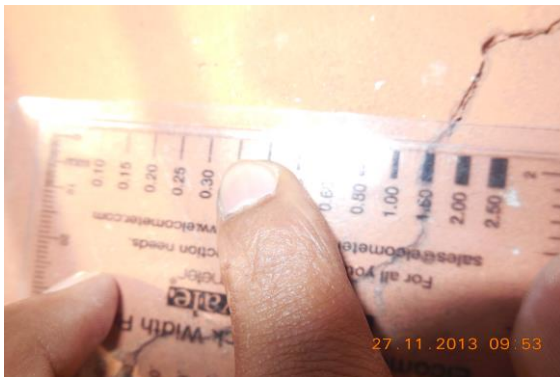
Photo 15

Inclined Crack on Wall No. 1 of Stair GF to FF, First Floor, Approx.

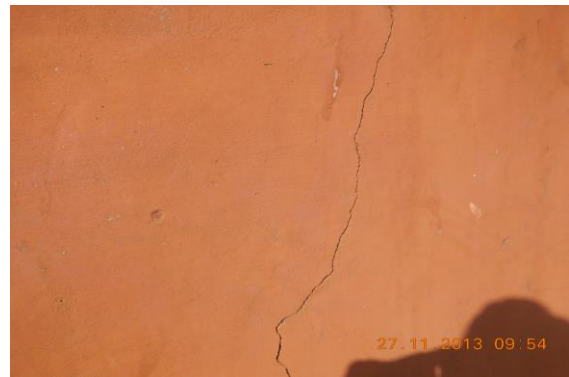
Horizontal Crack on Wall No. 1 of Stair GF to FF, First Floor, Approx.

Width = 1.5mm, Approx. Length = 1.6m.

Distance from w3 = 0.2m, Height from Floor = 1.4m.

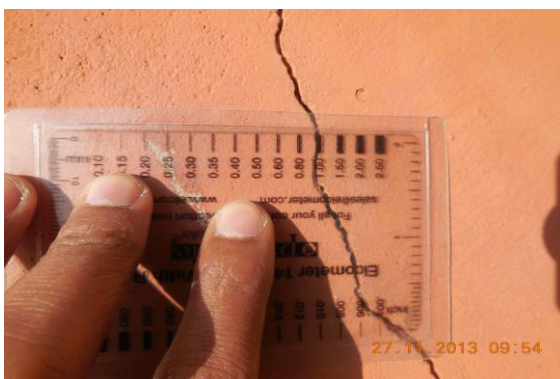
Photo 16

Inclined Crack on Wall No. 1 of Stair GF to FF, First Floor, Approx.

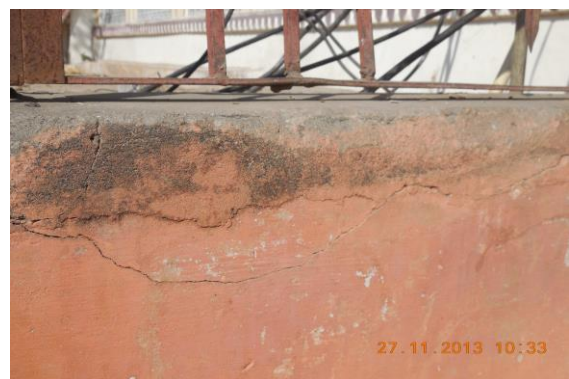
Inclined Crack on Wall No. 1 of Stair GF to FF, First Floor, Approx.

Distance from w4 = 1.4m, Height from Floor = 0m.

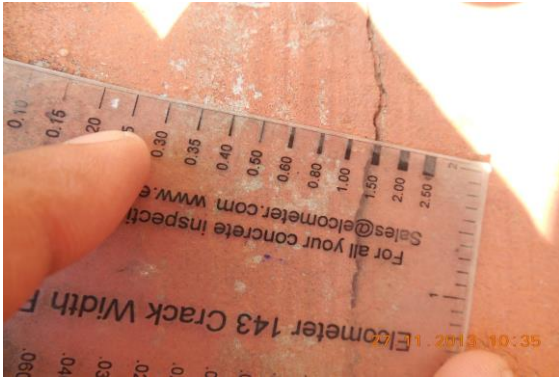
Photo 16A

Inclined Crack on Wall No. 1 of Stair GF to FF, First Floor, Approx.  
Width = 1.5mm, Approx. Length = 1.75m.  
Distance from w4 = 1.2m, Height from Floor = 0.7m.

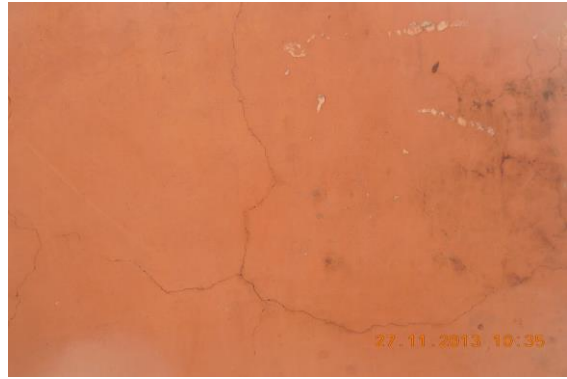
Photo 17

Horizontal Crack on Wall No. 2 of Stair GF to FF, First Floor, Approx.  
Width = 1.5mm, Approx. Length = 3m.  
Distance from w4 = 1.9m, Height from Floor = 0m.

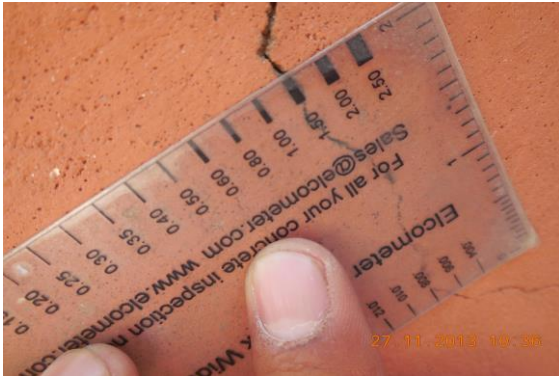
Photo 17A

Horizontal Crack on Wall No. 2 of Stair GF to FF, First Floor, Approx.  
Width = 1.5mm, Approx. Length = 3m.  
Distance from w4 = 1.9m, Height from Floor = 0m.

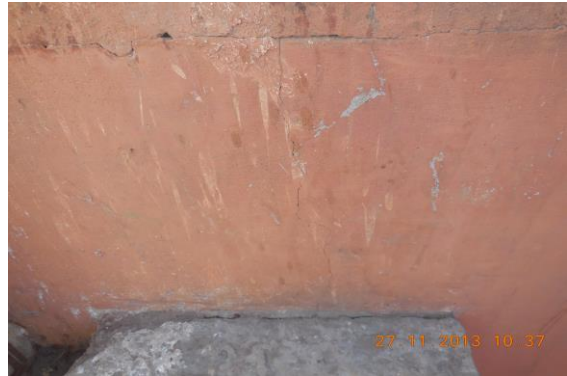
Photo 18

Inclined Crack on Wall No. 2 of Stair GF to FF, First Floor  
Approx. Width = 0.6mm, Approx. Length = 0.5m.  
Distance from w4 = 0.4m, Height from Floor = 0.5m.

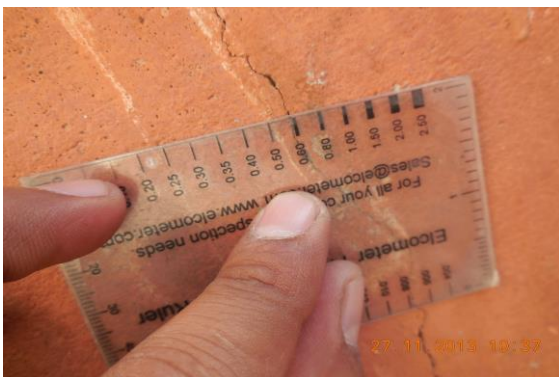
Photo 18A

Inclined Crack on Wall No. 2 of Stair GF to FF, First Floor, Approx.  
Width = 0.6mm, Approx. Length = 0.5m.  
Distance from w4 = 0.4m, Height from Floor = 0.5m.

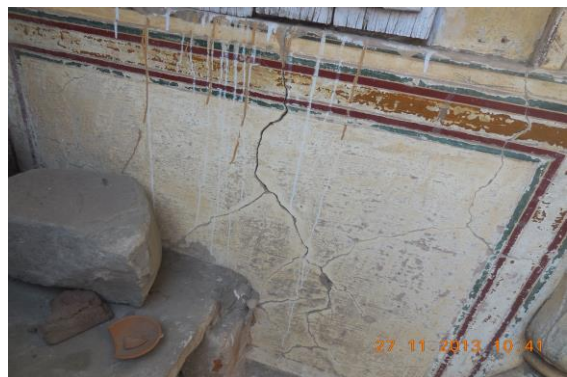
Photo 19

Inclined Crack on Wall No. 1 of Open Area, First Floor, Approx. Width =  
2.5mm, Approx. Length = 2m.  
Distance from w3 = 1.2m, Height from Floor = 0m.

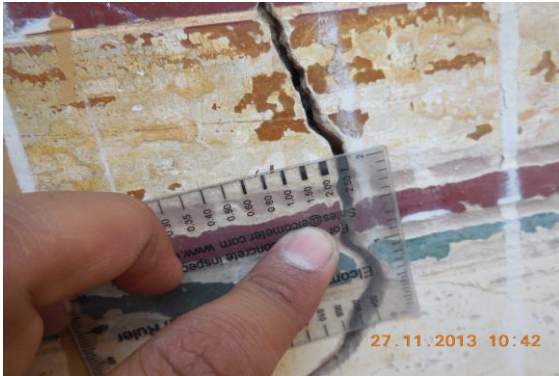
Photo 19A

Inclined Crack on Wall No. 1 of Open Area, First Floor, Approx. Width = 2.5mm, Approx. Length = 2m.  
Distance from w3 = 1.2m, Height from Floor = 0m.

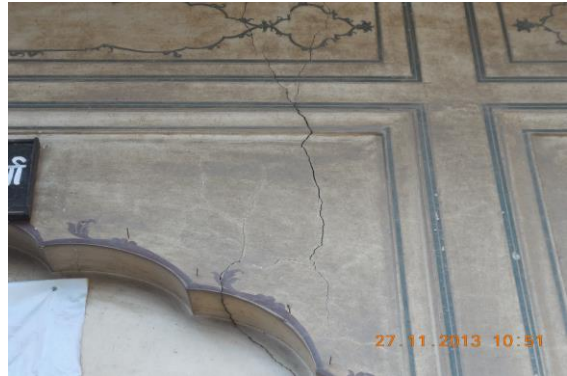
Photo 20

Inclined Crack on Wall No. 1 of Open Area, First Floor, Approx. Width = 1mm, Approx. Length = 2.5m.  
Distance from w3 = 3.7m, Height from Floor = 2m.

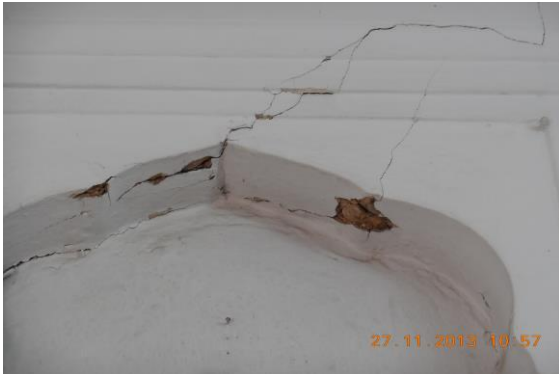
Photo 21

Inclined Crack on Wall No. 1 of Office 1, First Floor, Approx. Width = 7mm, Approx. Length = 2.3m.  
Distance from w3 = 0.3m, Height from Floor = 2.3m.

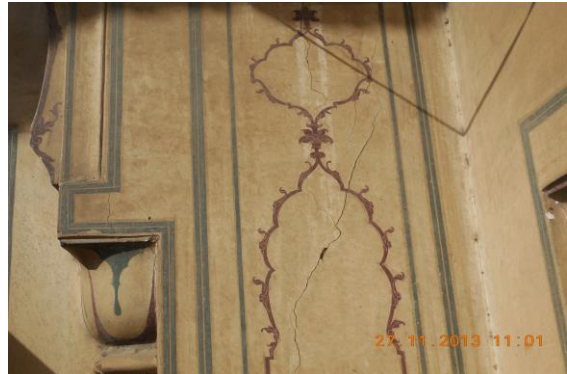
Photo 22

Inclined Crack on Wall No. 1 of Open Area, First Floor, Approx. Width = 0.6mm, Approx. Length = 3.5m.  
Distance from w8 = 0.2m, Height from Floor = 1.5m.

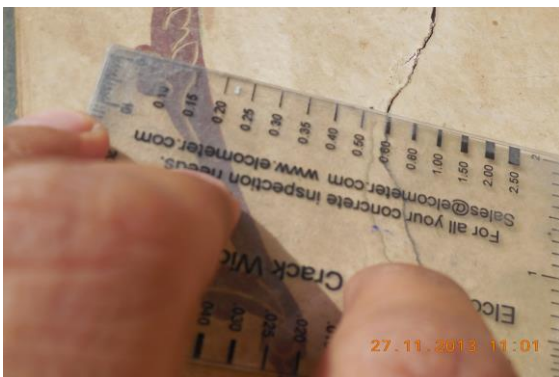
Photo 22A

Inclined Crack on Wall No. 1 of Open Area, First Floor, Approx. Width = 0.6mm, Approx. Length = 3.5m.  
Distance from w8 = 0.2m, Height from Floor = 1.5m.

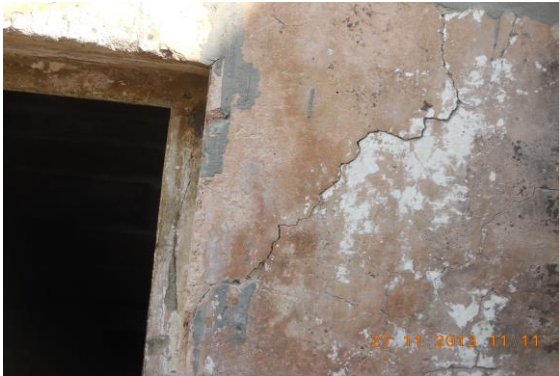
Photo 24

Inclined Crack on Wall No. 4 of Open Area, First Floor, Approx. Width = 2.5mm, Approx. Length = 2m.  
Distance from Wall No. 2 = 2.5m, Height from Floor = 1m.

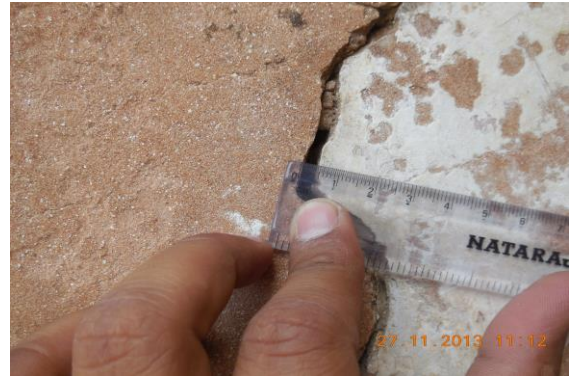
Photo 24A

Inclined Crack on Wall No. 4 of Open Area, First Floor, Approx. Width = 2.5mm, Approx. Length = 2m.  
Distance from Wall No. 2 = 2.5m, Height from Floor = 1m.

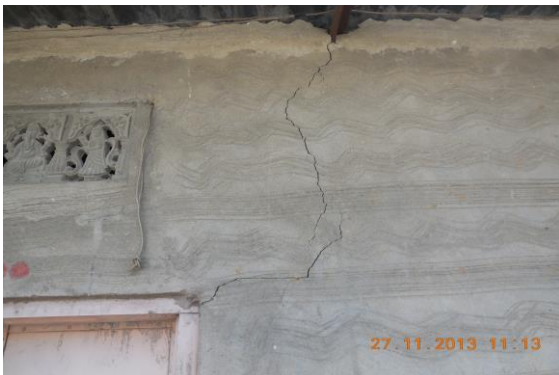
Photo 25

Inclined Crack on Wall No. 9 of Open Area, First Floor, Approx. Width = 2.5mm, Approx. Length = 1.3m.  
Distance from Wall No. 12 = 2m, Height from Floor = 1.9m.

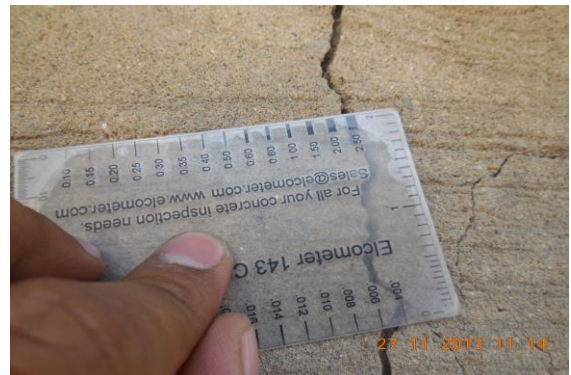
Photo 25A

Inclined Crack on Wall No. 9 of Open Area, First Floor, Approx. Width = 2.5mm, Approx. Length = 1.3m.  
Distance from Wall No. 12 = 2m, Height from Floor = 1.9m.

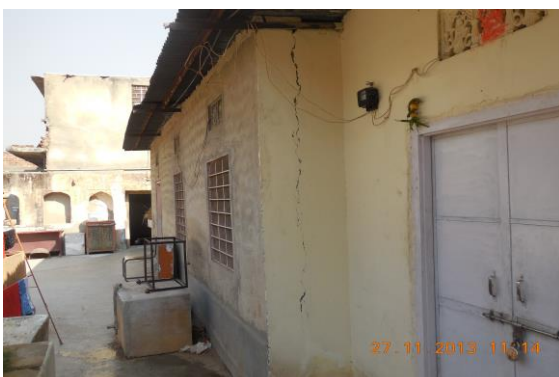
Photo 26

Vertical Crack on Wall No. 13 of Open Area, First Floor, Approx. Width = 9mm, Approx. Length = 3m.  
Distance from Wall No. 9 = 0.25m, Height from Floor = 0m.

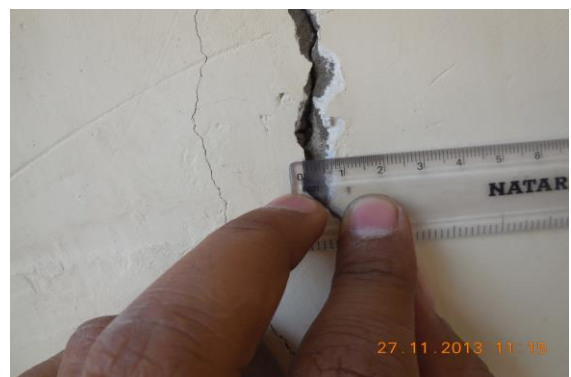
Photo 26A

Vertical Crack on Wall No. 13 of Open Area, First Floor, Approx. Width = 9mm, Approx. Length = 3m.  
Distance from Wall No. 9 = 0.25m, Height from Floor = 0m.

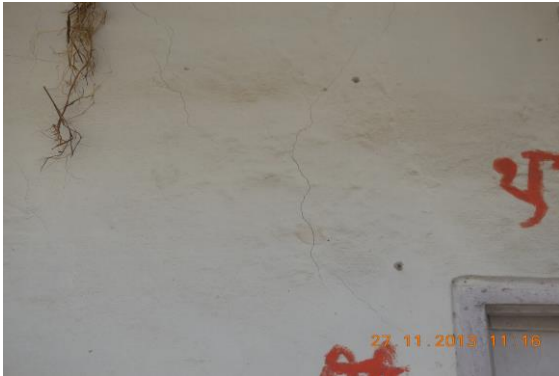
Photo 27

Inclined Crack on Wall No. 9 of Open Area, First Floor, Approx. Width = 0.5mm, Approx. Length = 2.2m.  
Distance from Wall No. 10 = 2.1m, Height from Floor = 1.9m.

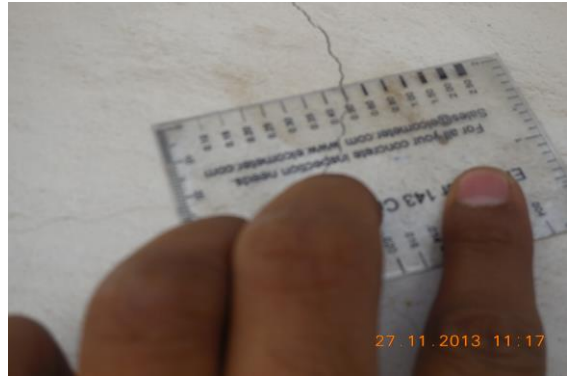
Photo 27A

Inclined Crack on Wall No. 9 of Open Area, First Floor, Approx. Width = 0.5mm, Approx. Length = 2.2m.  
Distance from Wall No. 10 = 2.1m, Height from Floor = 1.9m.

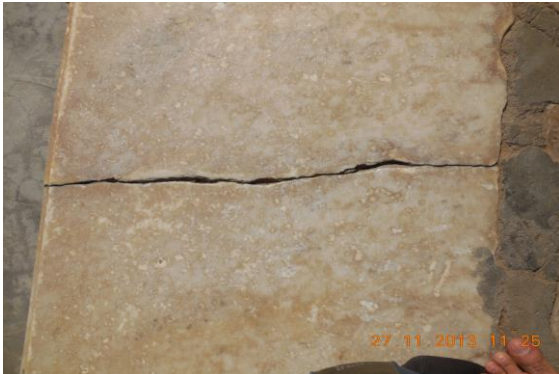
Photo 28

Horizontal Crack on Floor of Varanda, First Floor, Approx. Width = 8mm, Approx. Length = 0.35m.  
Distance from Wall No. 1 = 1.5m, Height from Floor = 0m.

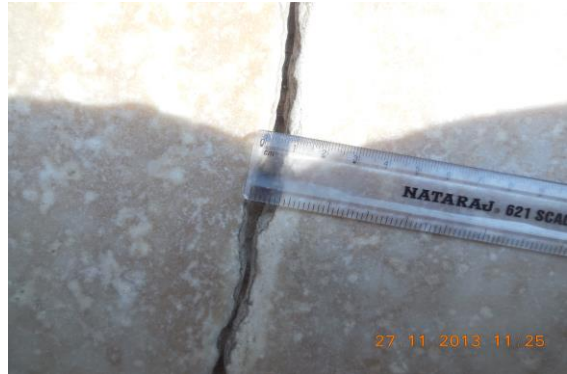
Photo 28A

Horizontal Crack on Floor of Varanda, First Floor, Approx. Width = 8mm, Approx. Length = 0.35m.  
Distance from Wall No. 1 = 1.5m, Height from Floor = 0m.

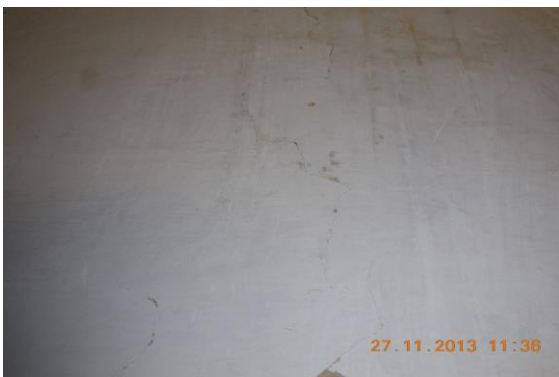
Photo 29

Inclined Crack on Wall No. 4 of Passage 2, First Floor, Approx. Width = 0.35mm, Approx. Length = 3m.  
Distance from Wall No. 4 = 0m, Height from Floor = 1.7m.

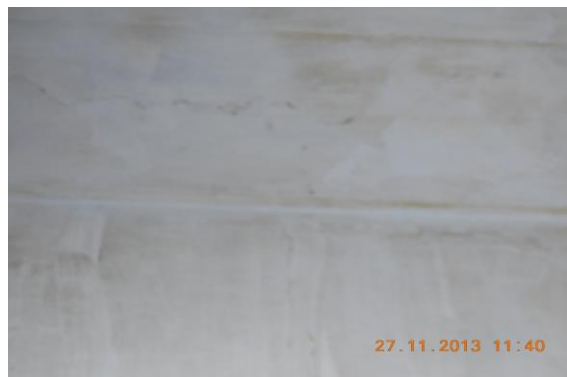
Photo 30

Horizontal Crack on Roof of Passage 2, First Floor, Approx. Width = 0.35mm, Approx. Length = 6m.  
Distance from Wall No. 3 = 0m, Height from Floor = 2.5m.

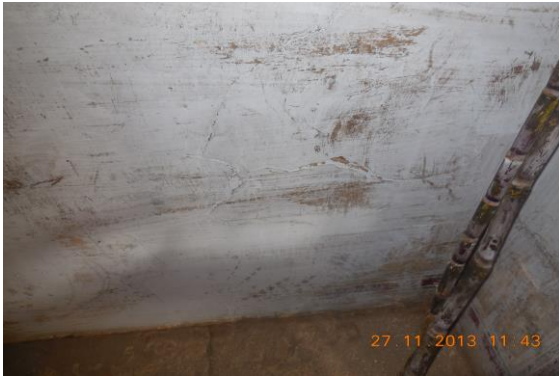
Photo 31

Inclined Crack on Wall No. 2 of Passage 2, First Floor, Approx. Width = 12mm, Approx. Length = 1.2m.  
Distance from Wall No. 3 = 0.4m, Height from Floor = 0m.

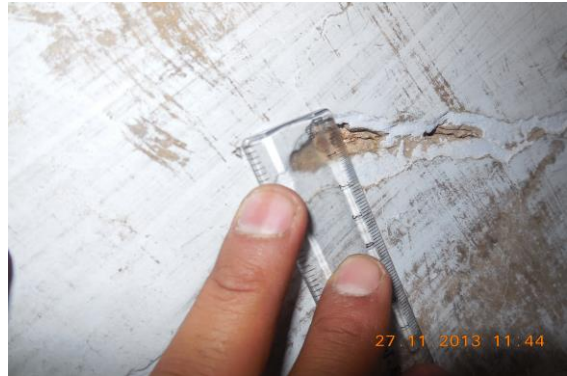
Photo 31A

Inclined Crack on Wall No. 2 of Passage 2, First Floor, Approx. Width = 12mm, Approx. Length = 1.2m.  
Distance from Wall No. 3 = 0.4m, Height from Floor = 0m.

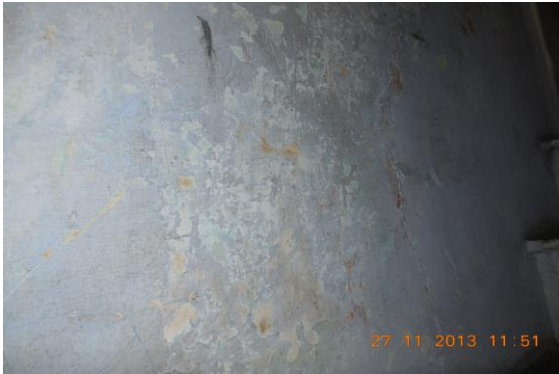
Photo 32

Inclined Crack on Wall No. 1 of Stair 4, First Floor, Approx. Width = 2mm, Approx. Length = 1.7m.  
Distance from Wall No. 3 = 0.2m, Height from Floor = 0m.

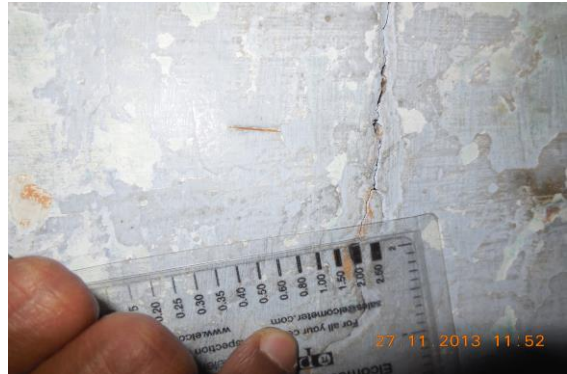
Photo 32A

Inclined Crack on Wall No. 1 of Stair 4, First Floor, Approx. Width = 2mm, Approx. Length = 1.7m.  
Distance from Wall No. 3 = 0.2m, Height from Floor = 0m.

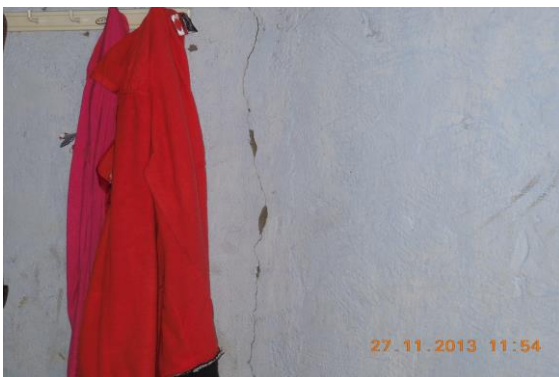
Photo 33

Vertical Crack on Wall No. 2 of Room No. 1, Second Floor, Approx. Width = 0.8mm, Approx. Length = 2.2m.  
Distance from Wall No. 2 = 1.2m, Height from Floor = 0m.

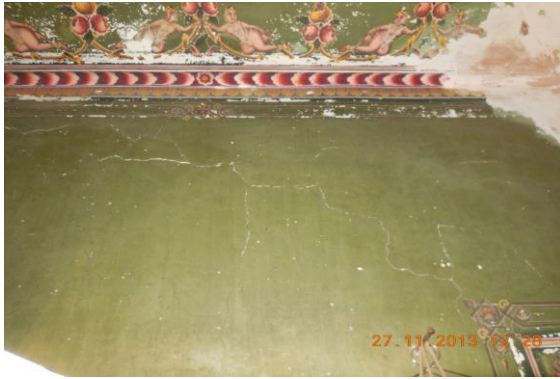
Photo 35

Inclined Crack on Wall No. 4 of Room No. 2, Ground Floor, Approx.  
Width = 1.5mm, Approx. Length = 5.5m.  
Distance from Wall No. 2 = 0.3m, Height from Floor = 0.6m.

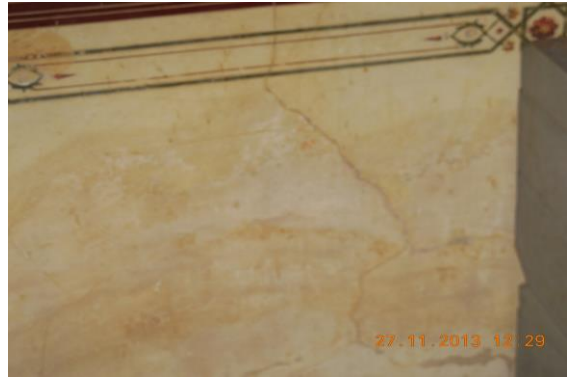
Photo 35A

Inclined Crack on Wall No. 4 of Room No. 2, Ground Floor, Approx.  
Width = 1.5mm, Approx. Length = 5.5m.  
Distance from Wall No. 2 = 0.3m, Height from Floor = 0.6m.
