### Pre Building Condition Survey Report

Name and Address of Structure :	Badi Chopar to Ramp Area (UP Line)
---------------------------------	------------------------------------

Name of the Project	<b>Contract JMRC-UG1B</b> “Design and Construction of Tunnel between Chandpole and Badi Chouper and reverse line by Shield TBM, Underground Metro Stations at Choti Chouper and Badi Chouper by Cut and Cover Methods on East West Corridor of Jaipur Metro Rail Corporation Limited .”	
Owner :

Pre Building Condition Survey Report Badi Chopar to Ramp Area (UP Line)

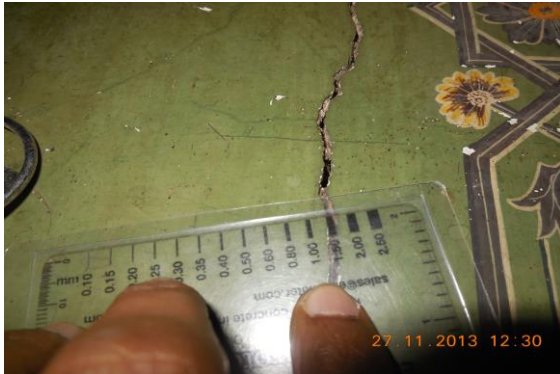
Photo 35A

Inclined Crack on Wall No. 4 of Room No. 2, Ground Floor, Approx.  
Width = 1.5mm, Approx. Length = 5.5m.  
Distance from Wall No. 2 = 0.3m, Height from Floor = 0.6m.

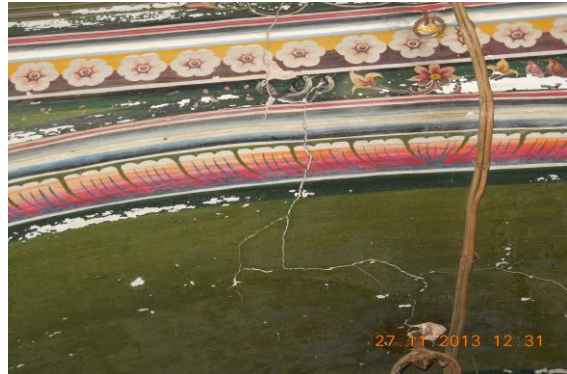
Photo 36

Inclined Crack on Wall No. 3 of Room No. 2, Ground Floor, Approx.  
Width = 1mm, Approx. Length = 1m.  
Distance from Wall No. 1 = 1.3m, Height from Floor = 2.1m.

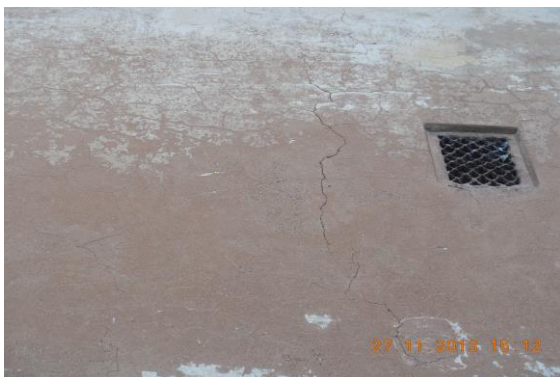
Photo 37

Inclined Crack on Left Side Of Building, External Façade, Approx.  
Width = 2.5mm, Approx. Length = 2.5m.  
Distance from Wall No. 2 = 3.5m, Height from Floor = 4m.

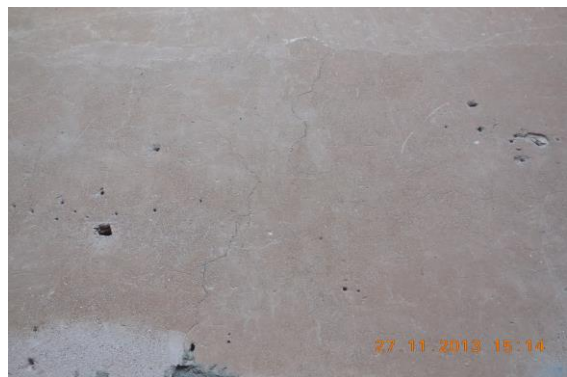
Photo 38

Inclined Crack on External Façade, Approx. Width = 1mm, Approx.  
Length = 3m.  
Distance from Wall No. 2 = 4.5m, Height from Floor = 2m.

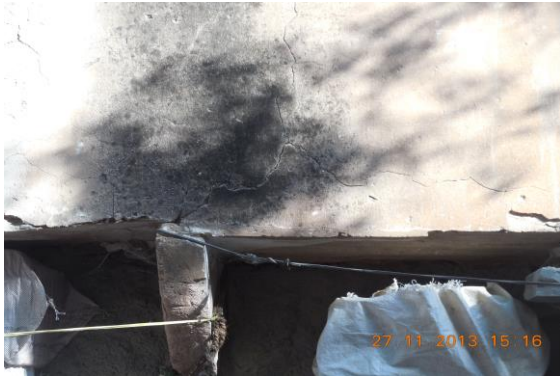
Photo 39

Inclined Crack on External Façade, Approx. Width = 2.5mm, Approx. Length = 2m.

Distance from Wall No. 1 = 6m, Height from Floor = 2m.

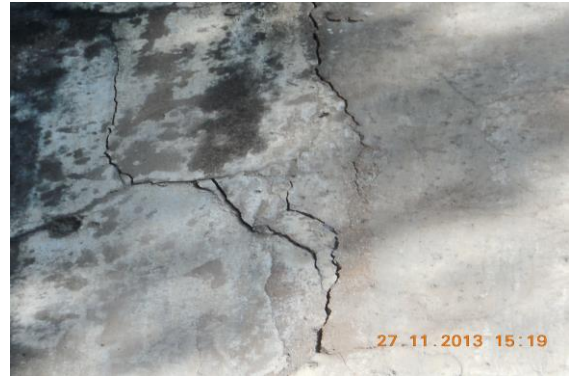
Photo 40

Inclined Crack on External Façade, Approx. Width = 2.5mm, Approx. Length = 3m.

Distance from Wall No. 1 = 1m, Height from Floor = 5m.

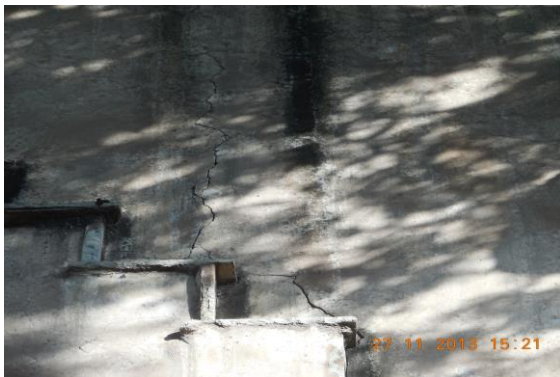
Photo 41

Inclined Crack on External Façade, Approx. Width = 3mm, Approx. Length = 2m.

Distance from Wall No. 1 = 2m, Height from Floor = 7m.

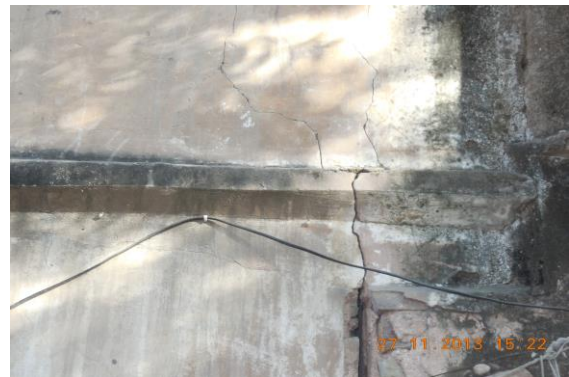
Photo 42

Inclined Crack on External Façade, Approx. Width = 5mm, Approx. Length = 2.5m.

Distance from Wall No. 1 = 2m, Height from Floor = 2m.

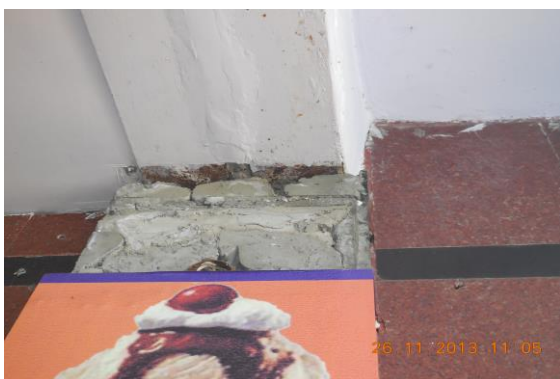
Photo 43

Tiles removal Wall No.2 of Shop No.354 of Ground Floor

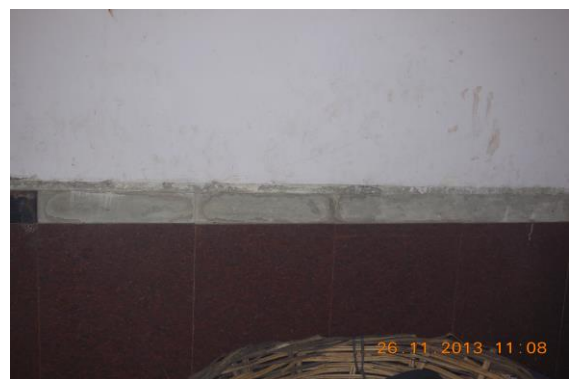
Photo 44

Tiles removal Wall No. 4 of Shop No.354 of Ground Floor

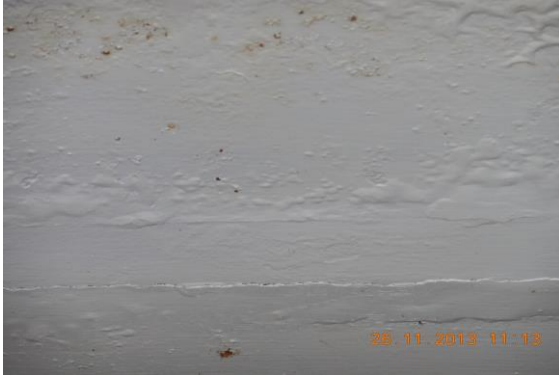
Photo 45  
Peeling of Plaster on Roof of Shop No.354 of Ground Floor

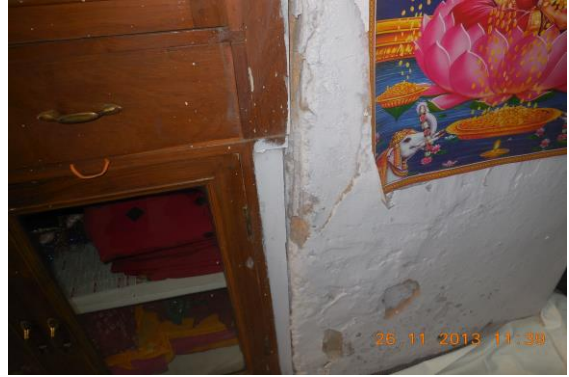
Photo 46  
Peeling of Plaster on Entry Gate of Part C of Leftside Wall Part C of Shop No.350 of Ground Floor

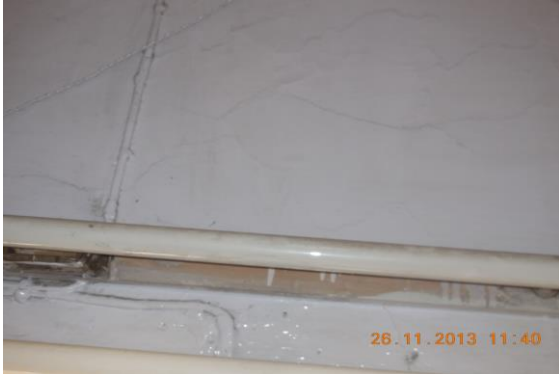
Photo 47  
Peeling of Plaster on Wall No. 3 of Part A of Shop No.350 of Ground Floor

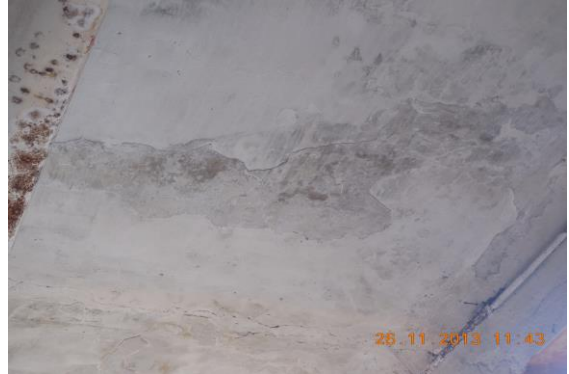
Photo 48  
Dampness/Seepage on Roof of Varanda of Shop No.350 of Ground Floor

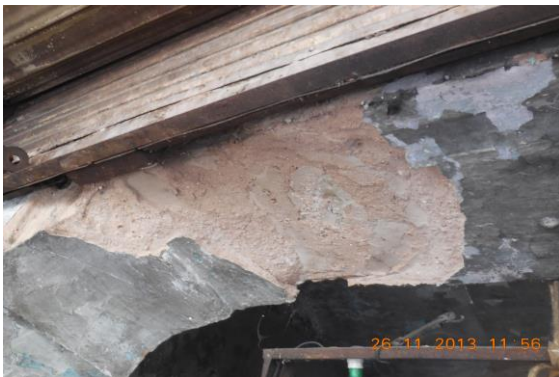
Photo 49  
Peeling of Plaster on Entry Gate Roof of Part A of Shop No.351 of Ground Floor

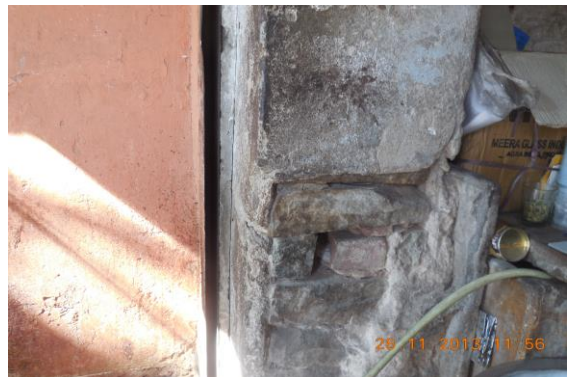
Photo 50  
Damaged Portion on Entry Gate Wall a of Left Side Part A of Shop No.351 of Ground Floor

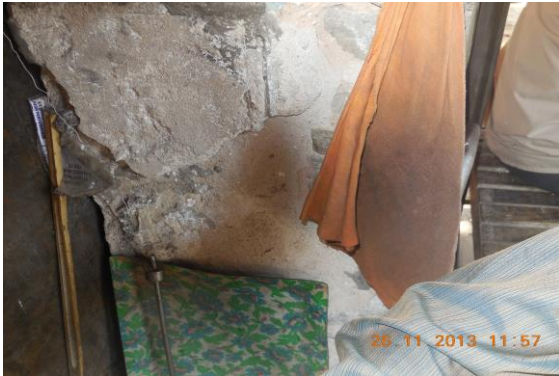
Photo 51

Damaged Portion on Entry Gate Wall B of Left Side Part A of Shop No.351 of Ground Floor

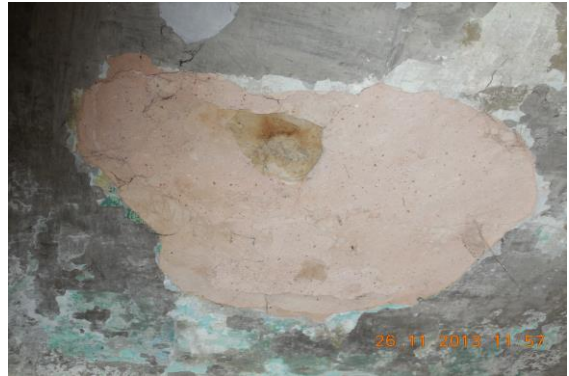
Photo 52

Peeling of Plaster on Roof of Part A of Shop No.351 of Ground Floor

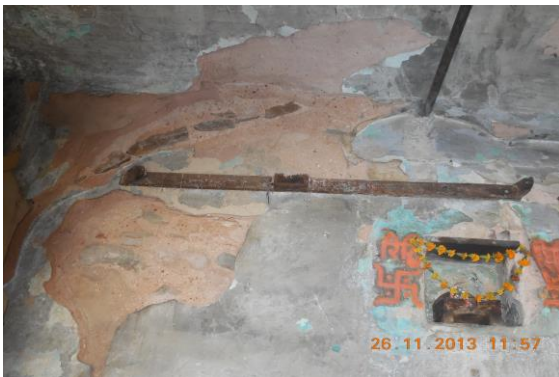
Photo 53

Dampness/Seepage on Wall No. 4 & Roof of Part A of Shop No.351 of Ground Floor

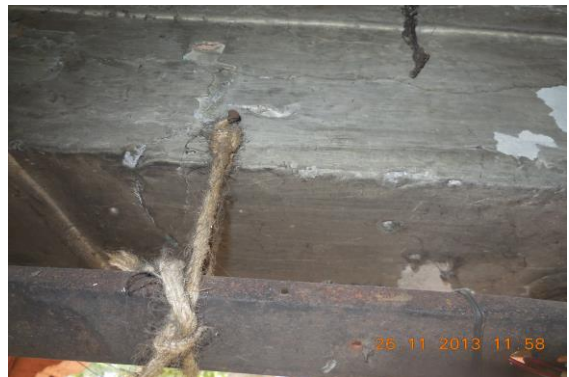
Photo 54

Peeling of Plaster on Wall No. 3 of Part A of Shop No.351 of Ground Floor

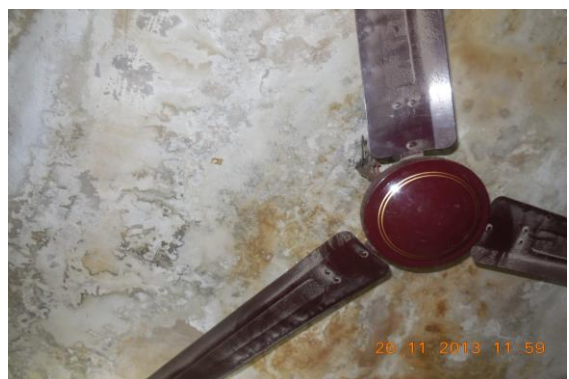
Photo 56

Dampness/Seepage on Roof of Part B of Shop No.351 of Ground Floor

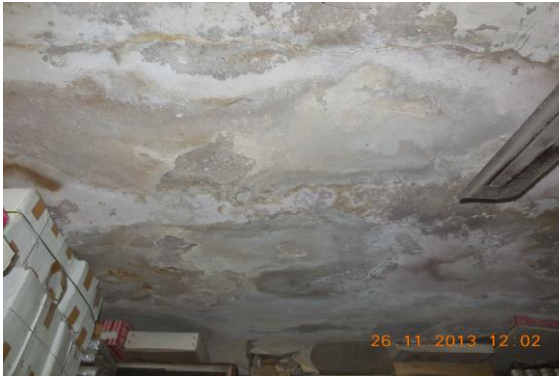
Photo 57

Dampness/Seepage on Roof of Part C of Shop No.351 of Ground Floor

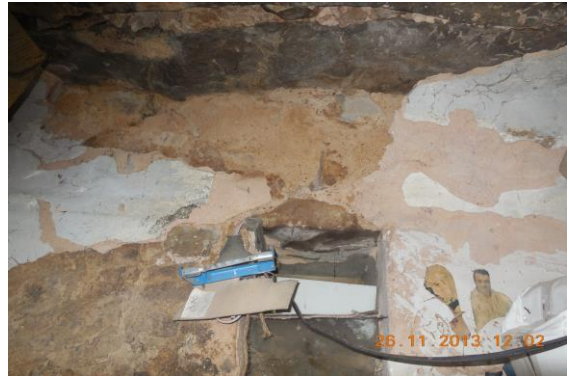
Photo 58

Damaged Portion on Wall No. 3 of Part D of Shop No.351 of Ground Floor

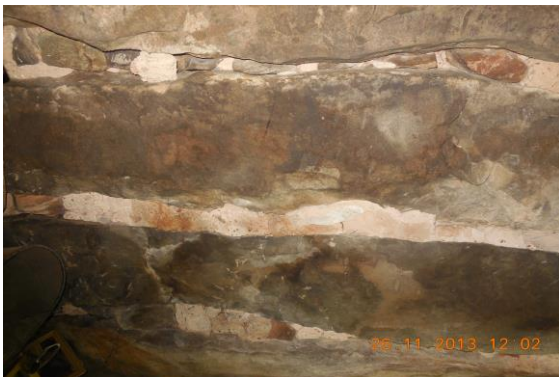
Photo 59

Damaged Portion on Roof of Part D of Shop No.351 of Ground Floor

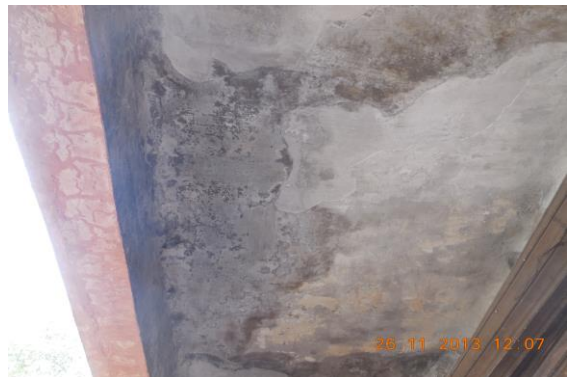
Photo 60

Dampness/Seepage on Roof of Varanda of Shop No.351 of Ground Floor

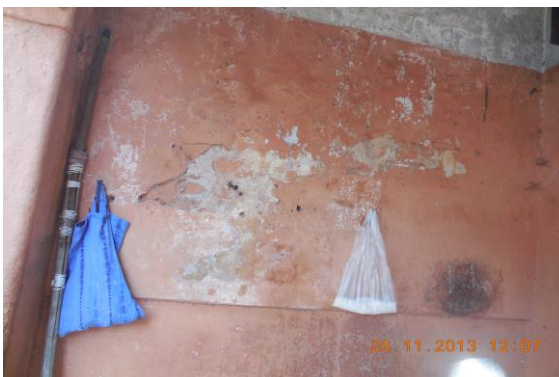
Photo 61

Peeling of Plaster on Wall No. 1 of Varanda of Shop No.351 of Ground Floor

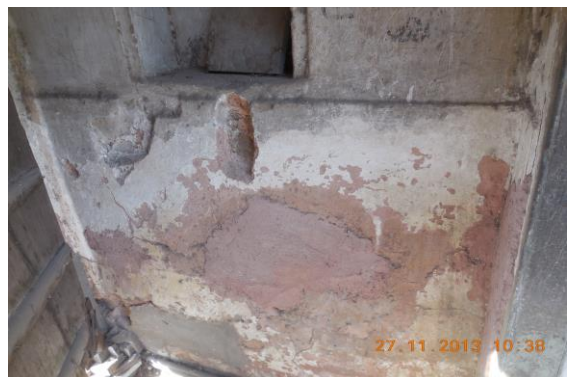
Photo 62

Damaged Portion on Wall No. 1 of Entrance of First Floor

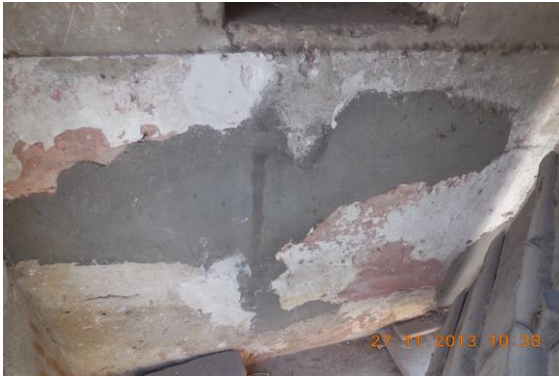
Photo 63  
Damaged Portion on Wall No. 2 of Entrance of First Floor

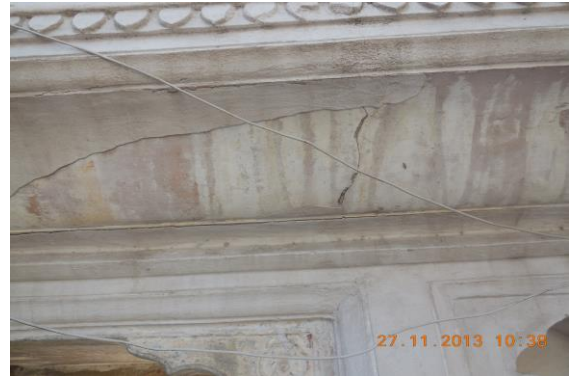
Photo 64  
Peeling of Plaster on Wall No. 3 of Entrance Open Area of First Floor

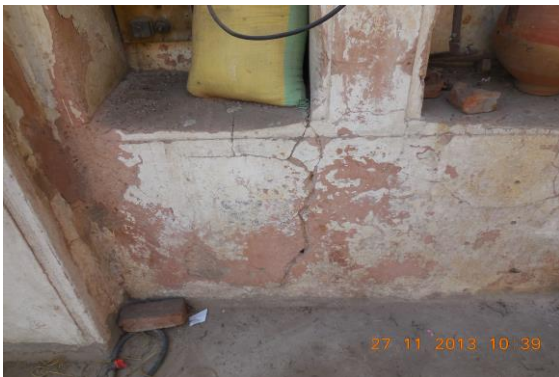
Photo 65  
Damaged Portion on Wall No. 3 of Entrance Open Area of First Floor

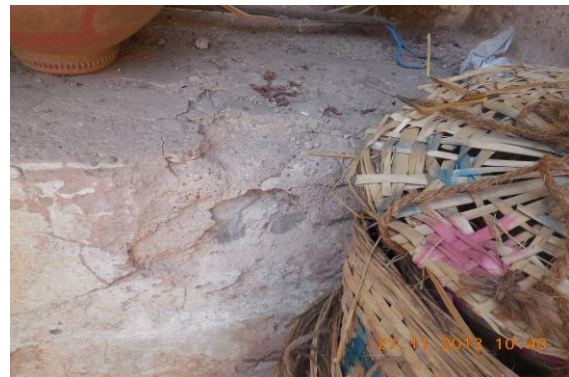
Photo 66  
Damaged Portion on Wall No. 3 of Entrance Open Area of First Floor

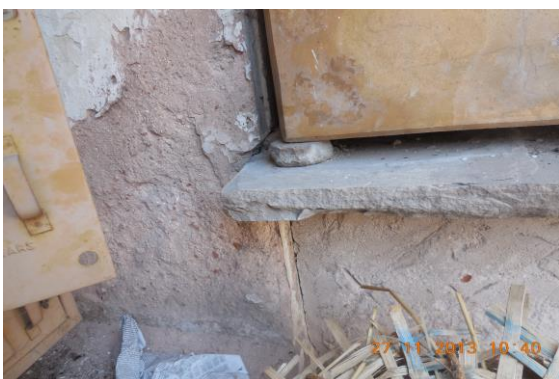
Photo 67  
Damaged Portion on Wall No. 3 of Entrance Open Area of First Floor

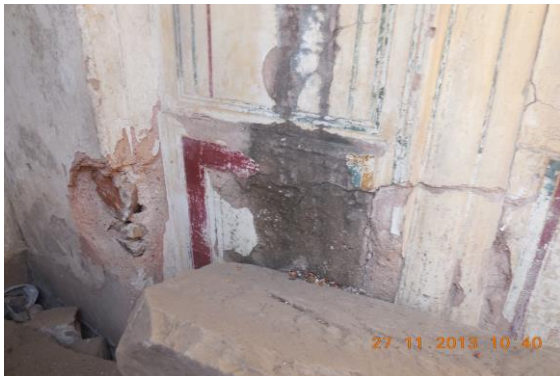
Photo 69  
Damaged Portion on Wall No. 1 of Open Area of First Floor

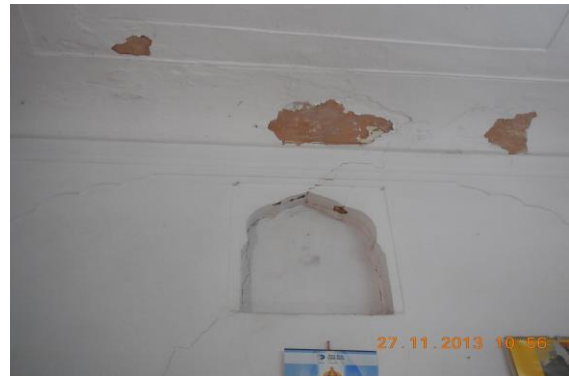
Photo 70  
Dampness/Seepage on Roof of Office 1 of First Floor

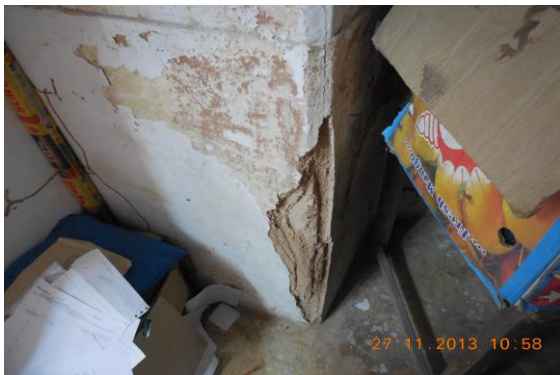
Photo 71  
Peeling of Plaster on Wall No. 4 of Store 1 of First Floor

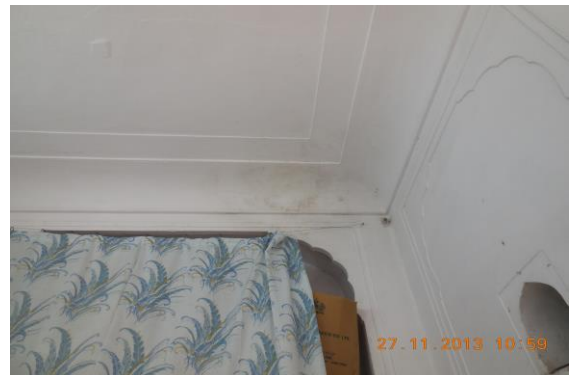
Photo 72  
Dampness/Seepage on Roof Office 1 of First Floor

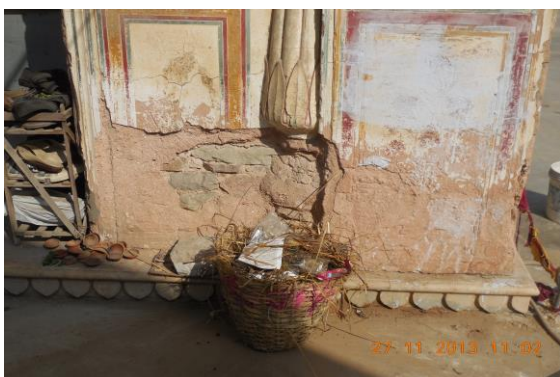
Photo 73  
Damaged Portion on Wall No. 8 of Open Area of First Floor

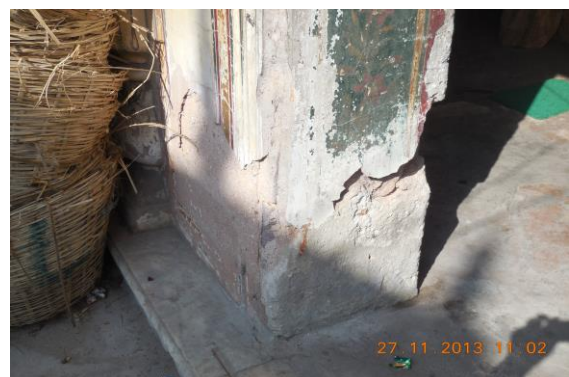
Photo 74  
Damaged Portion on Wall No. 8 of Open Area of First Floor

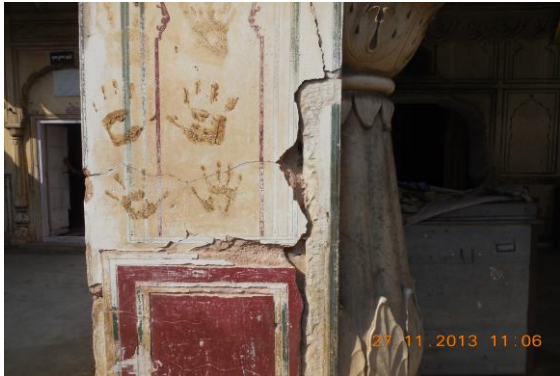
Photo 75  
Damaged Portion on Wall No. 1 of Gate Temple of First Floor

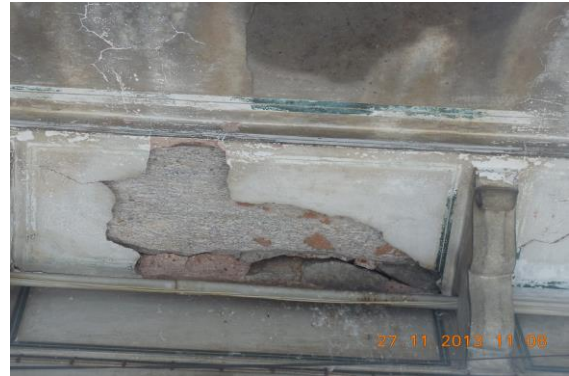
Photo 76  
Damaged Portion on Roof of Varandah Temple Gate 2 of First Floor

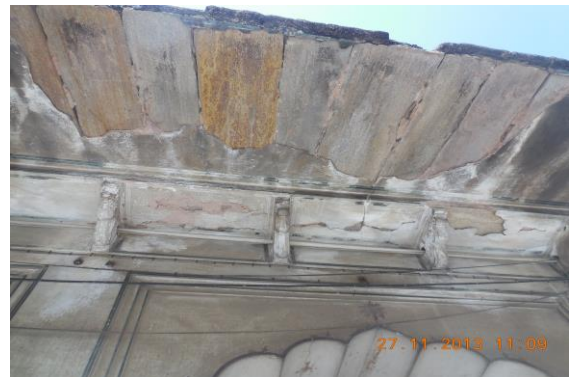
Photo 77  
Damaged Portion on Roof of Varandah Temple Gate 3 of First Floor

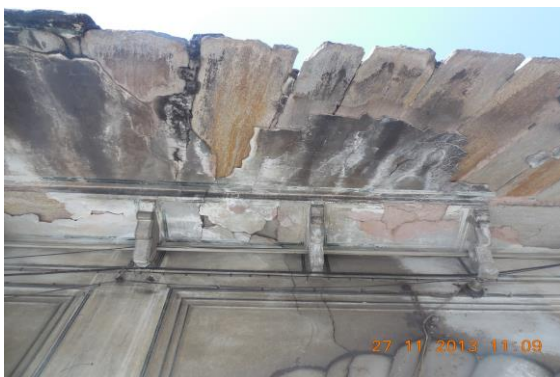
Photo 78  
Damaged Portion on Roof of Varandah Temple Gate 4 of First Floor

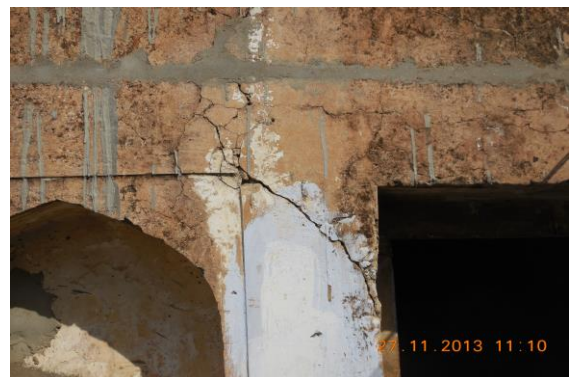
Photo 79  
Damaged Portion on Roof of Varandah Temple Gate 4 of First Floor

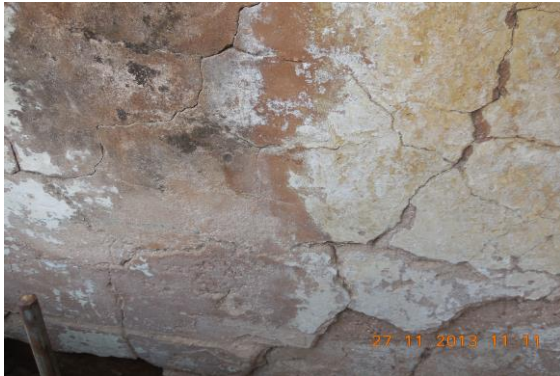
Photo 81

Damaged Portion on Wall No. 4 of Open Area of First Floor

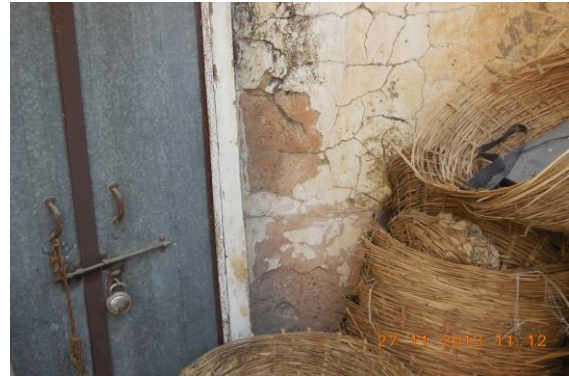
Photo 82

Damaged Portion on Wall No. 2 of Open Area of First Floor

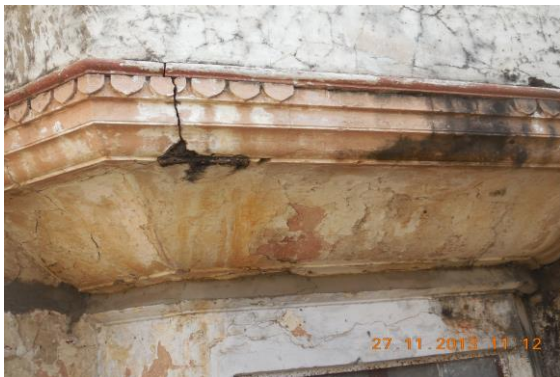
Photo 83

Damaged Portion on Gumbad 2 of First Floor

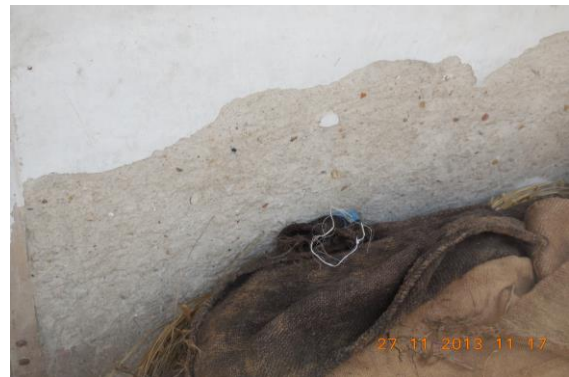
Photo 84

Peeling of Plaster on Wall No. 9 of Open Area of First Floor

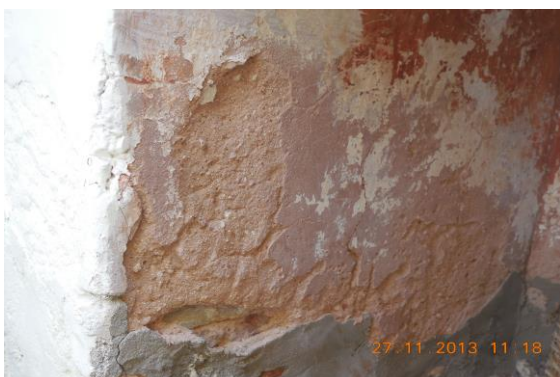
Photo 85

Damaged Portion on Stair Terrace of First Floor

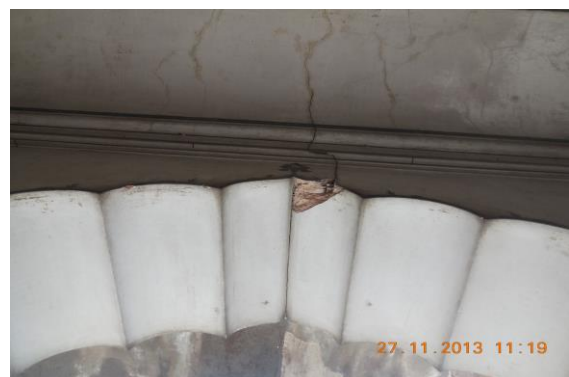
Photo 86

Damaged Portion on Roof of Varanda of First Floor

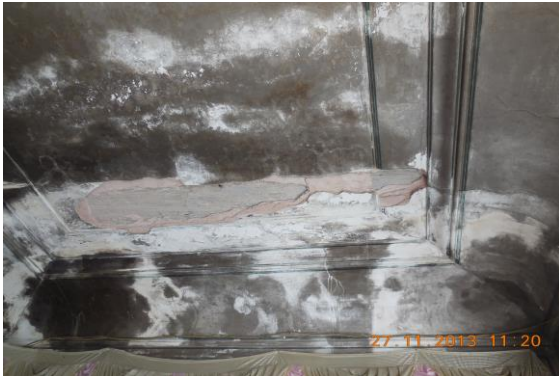
Photo 87  
Damaged Portion on Roof of Varanda of First Floor

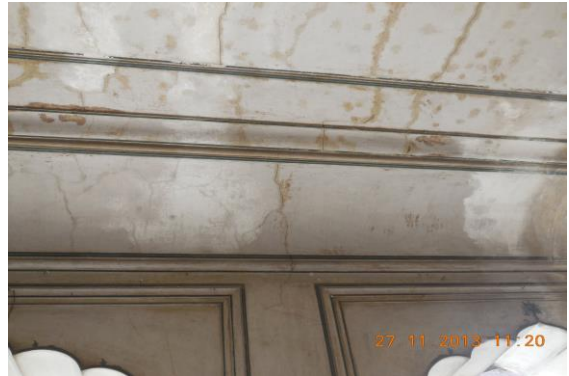
Photo 88  
Plaster Crack on Wall No. 1, 4 & Roof of Varanda of First Floor

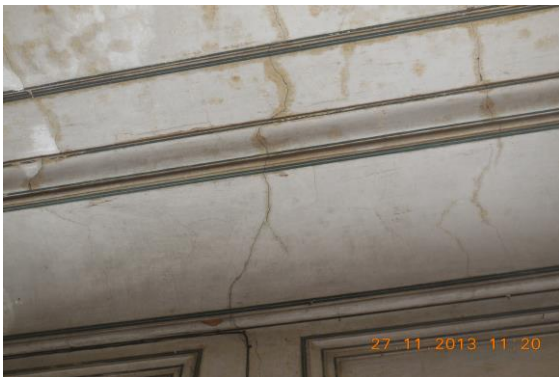
Photo 89  
Plaster Crack on Wall No. 1, 4 & Roof of Varanda of First Floor

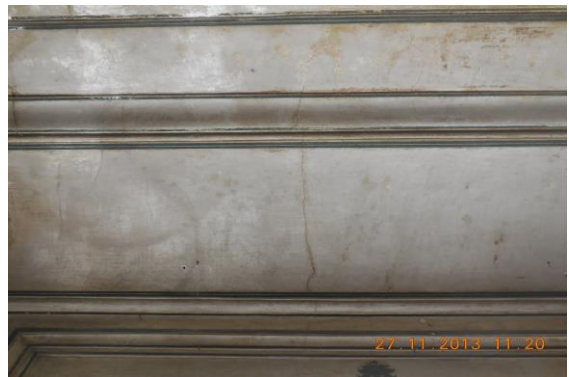
Photo 90  
Plaster Crack on Wall No. 1, 4 & Roof of Varanda of First Floor

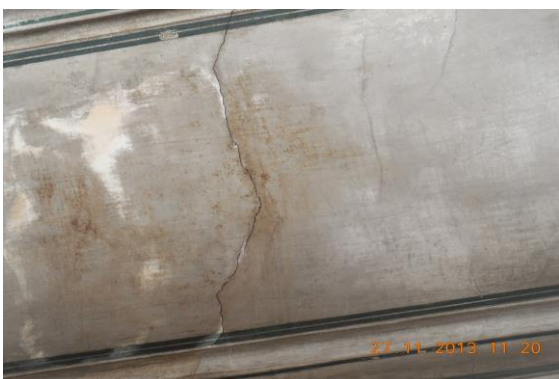
Photo 91  
Plaster Crack on Wall No. 1, 4 & Roof of Varanda of First Floor

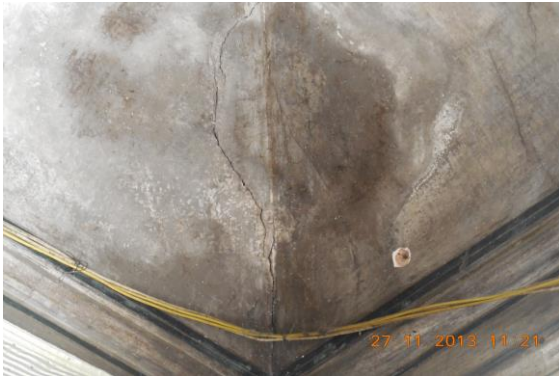
Photo 93  
Plaster Crack on Wall No. 1, 4 & Roof of Varanda of First Floor

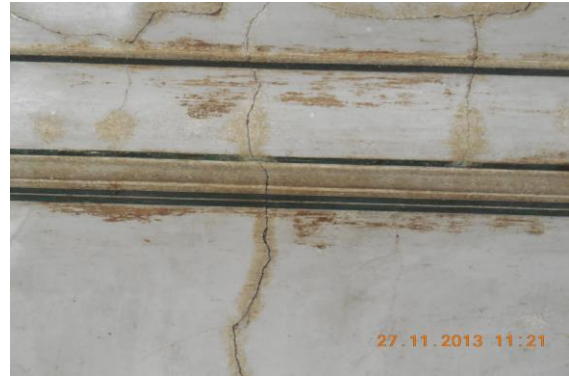
Photo 94  
Plaster Crack on Wall No. 1, 4 & Roof of Varanda of First Floor

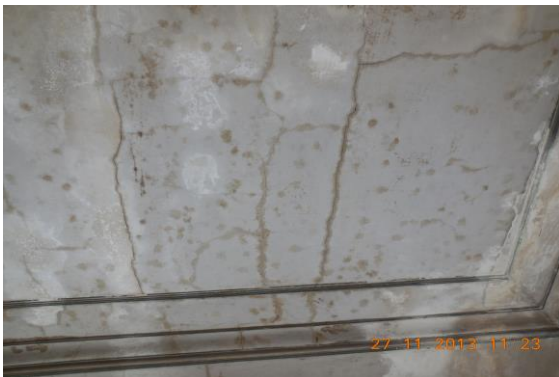
Photo 95  
Plaster Crack on Wall No. 1, 4 & Roof of Varanda of First Floor

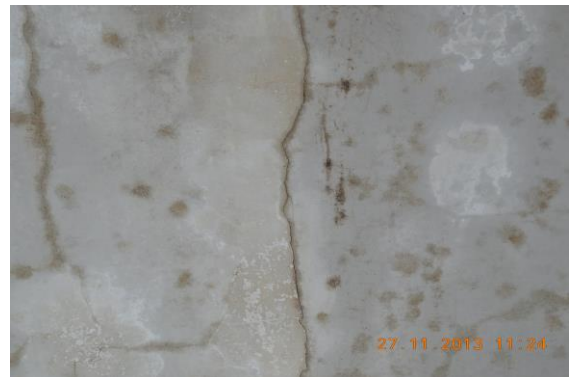
Photo 96  
Plaster Crack on Wall No. 1, 4 & Roof of Varanda of First Floor

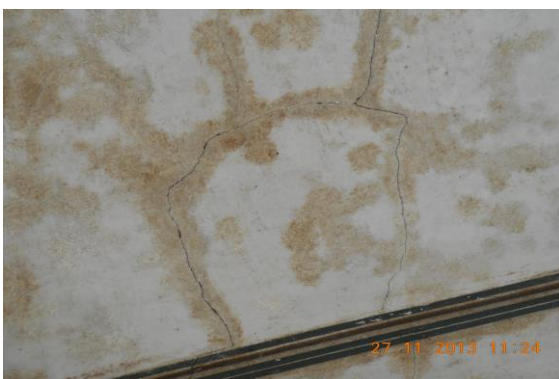
Photo 97  
Plaster Crack on Wall No. 1, 4 & Roof of Varanda of First Floor

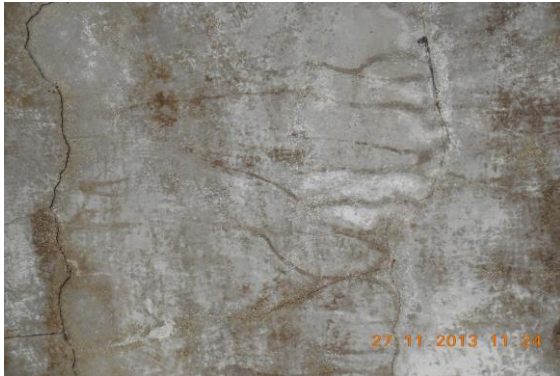
Photo 99  
Plaster Crack on Wall No. 1, 4 & Roof of Varanda of First Floor

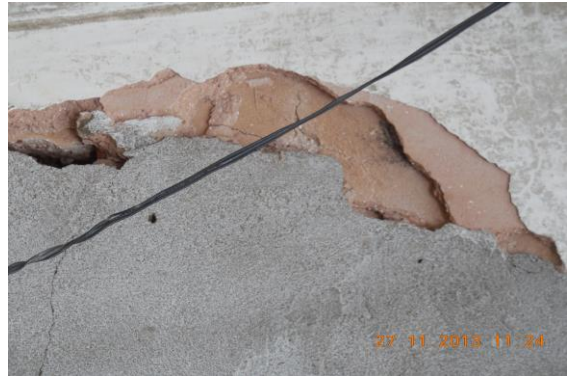
Photo 100  
Damaged Portion on Wall No. 2 of Varanda 1 of First Floor

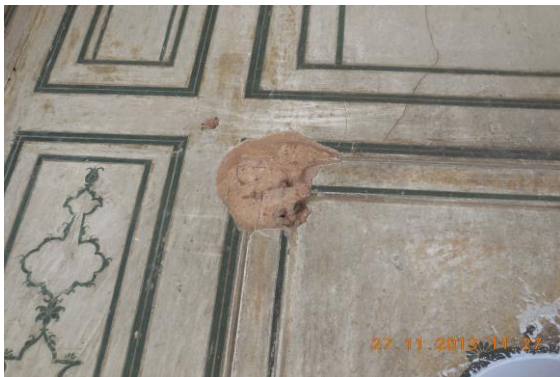
Photo 101  
Peeling of Plaster on Wall No. 4 of Varanda 1 of First Floor

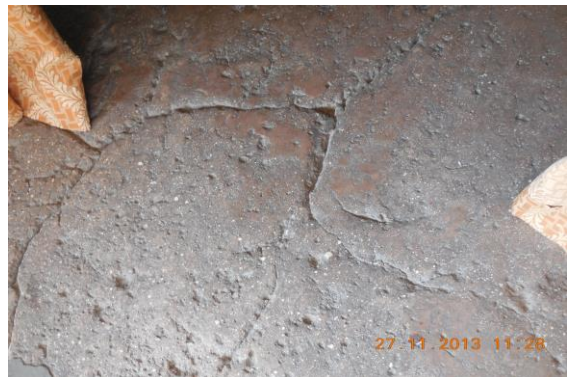
Photo 102  
Peeling of Plaster on Floor of Room No. 1 of First Floor

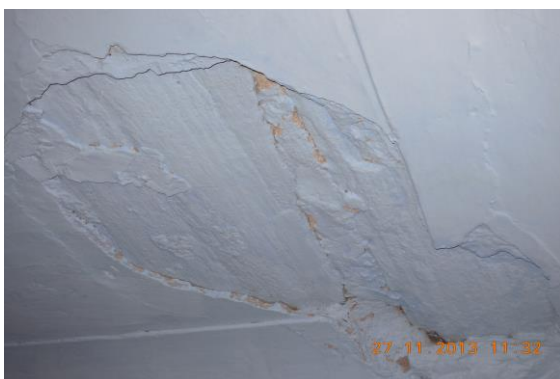
Photo 103  
Peeling of Plaster on Roof of Stair 2 of First Floor

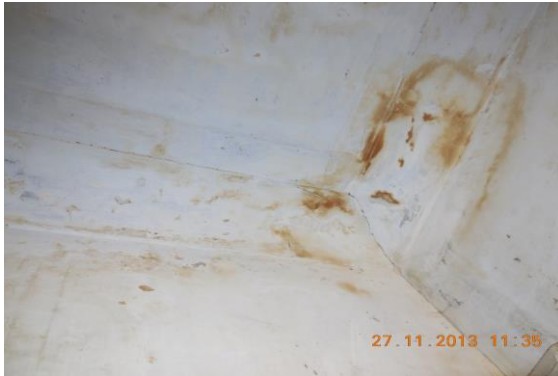
Photo 105

Dampness/Seepage on Wall No. 1, 4 & Roof of Passage 1 of First Floor

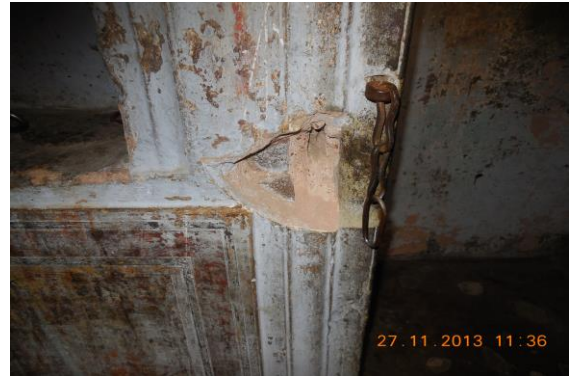
Photo 106

Peeling of Plaster on Wall No. 4 of Passage 2 of First Floor

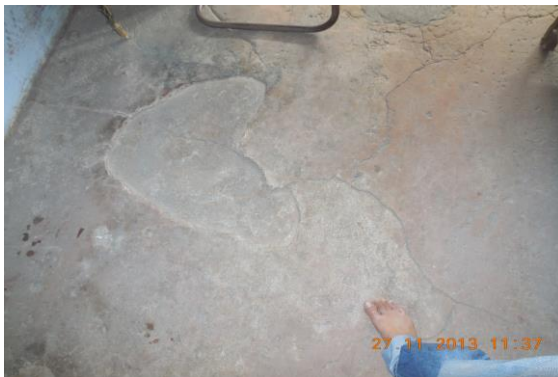
Photo 107

Peeling of Plaster on Floor of Passage 2 of First Floor

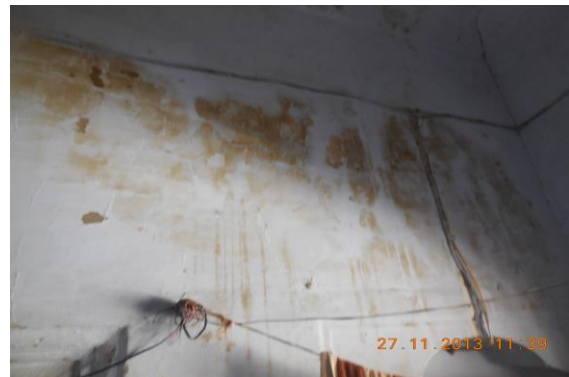
Photo 108

Dampness/Seepage on Wall No. 2 of Passage 2 of First Floor

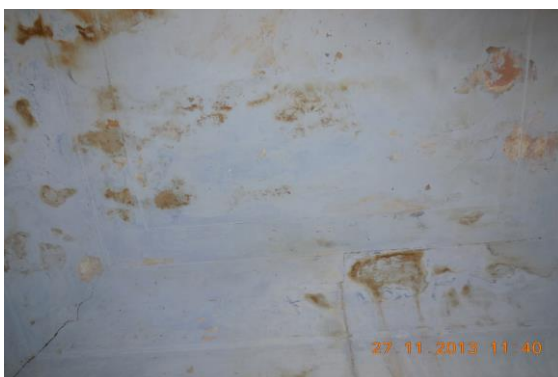
Photo 109

Peeling of Plaster on Roof of Passage 2 of First Floor

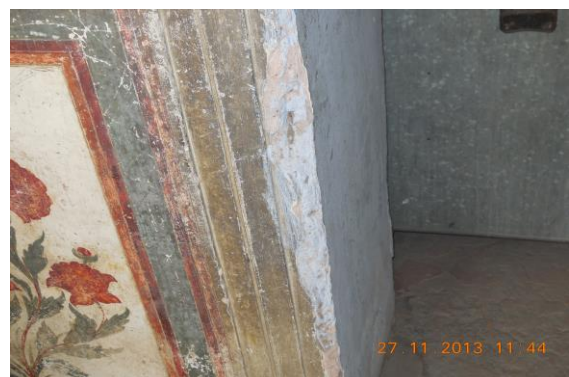
Photo 110

Peeling of Plaster on Outer Wall 3 of Passage 2 of First Floor

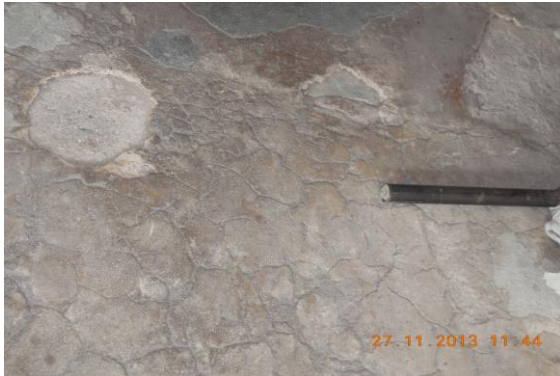
Photo 111  
Damaged Portion on Floor of Varandah Wall No. 1 of First Floor

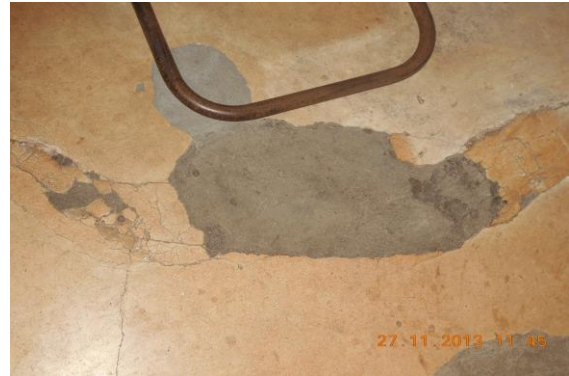
Photo 112  
Damaged Portion on Floor of Room No. 2 of First Floor

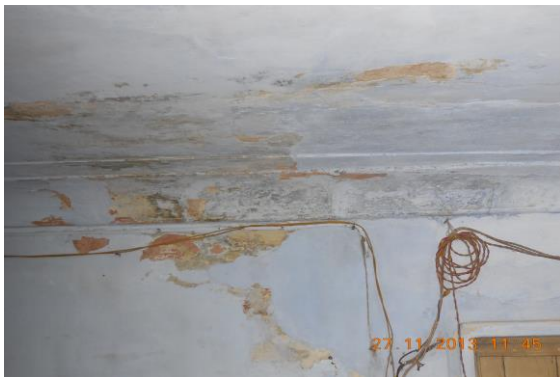
Photo 113  
Peeling of Plaster on Wall No. 1 of Room No. 2 of First Floor

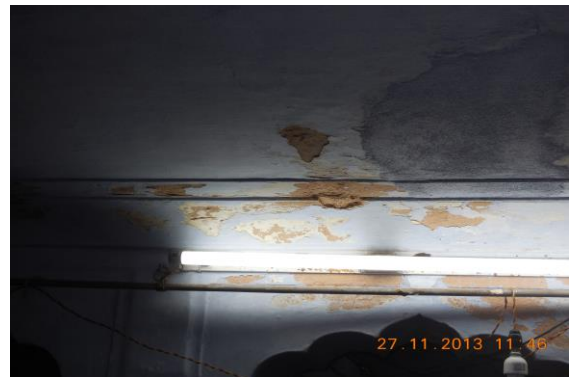
Photo 114  
Peeling of Plaster on Wall No. 4 of Room No. 2 of First Floor

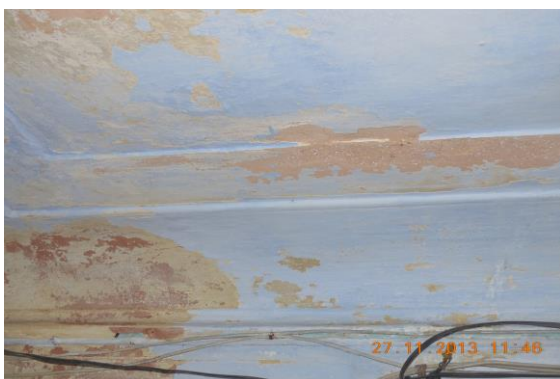
Photo 115  
Peeling of Plaster on Wall No. 2 of Room No. 2 of First Floor

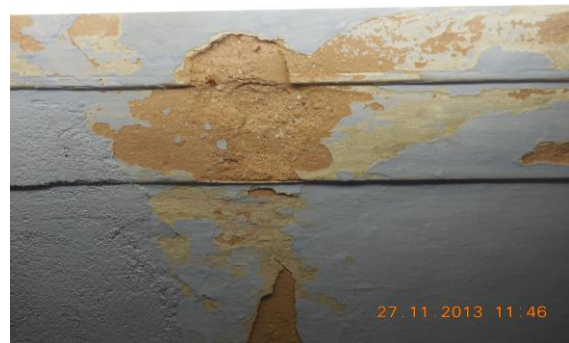
Photo 116  
Peeling of Plaster on Roof of Room No. 2 of First Floor

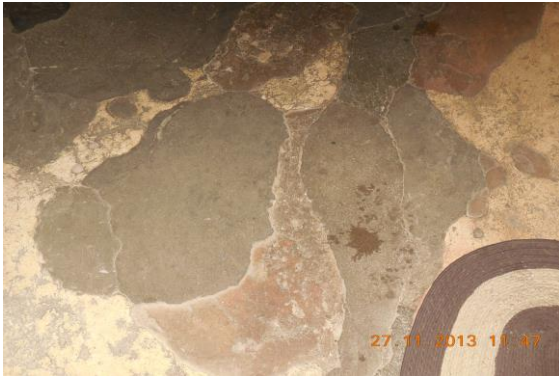
Photo 117  
Peeling of Plaster on Floor of Room No. 3 of First Floor

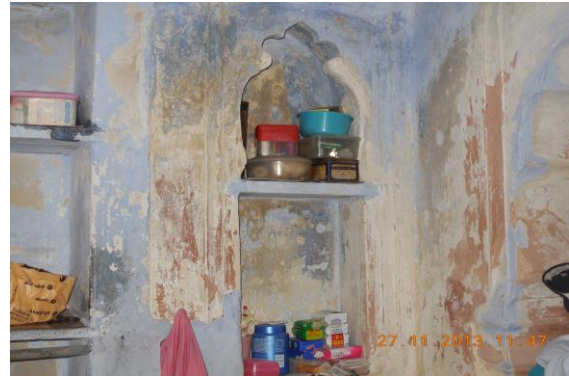
Photo 118  
Dampness/Seepage on Wall No. 2 & 4 of Bathroom 1 of First Floor

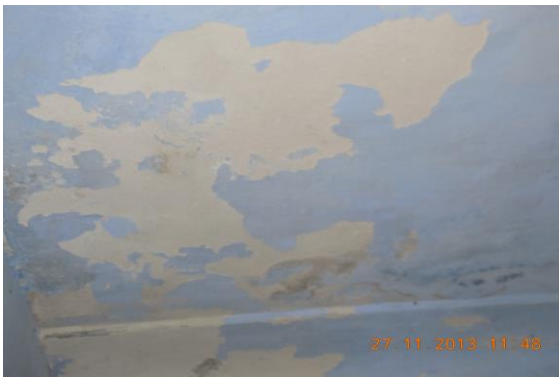
Photo 119  
Peeling of Plaster on Roof of Bathroom 1 of First Floor

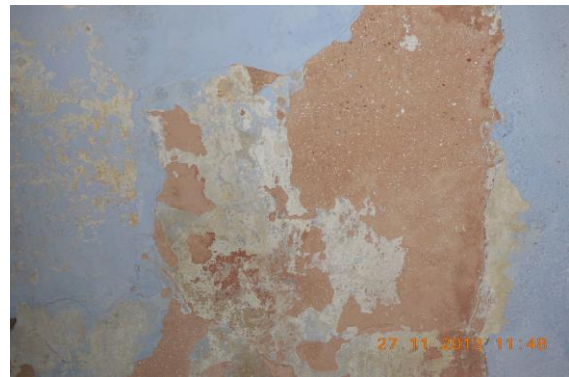
Photo 120  
Peeling of Plaster on Roof of Room No. 3 of First Floor

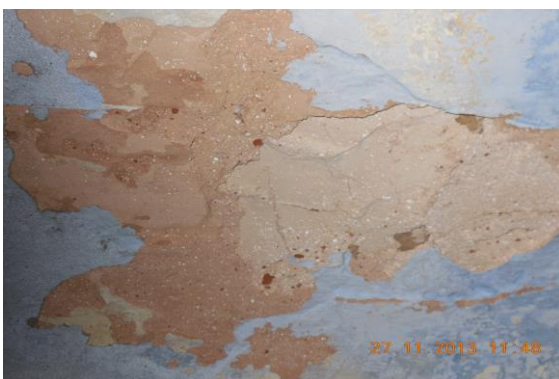
Photo 121  
Damaged Portion on Roof of Room No. 3 of First Floor

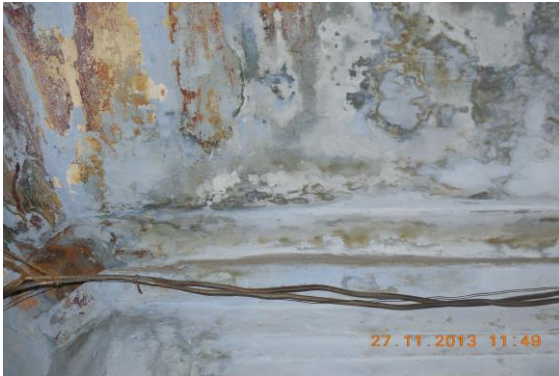
Photo 123

Dampness/Seepage on Wall No. 3 & Roof of Kitchen 1 of First Floor

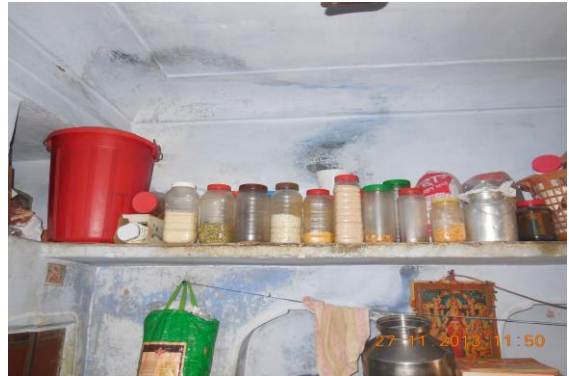
Photo 124

Dampness/Seepage on Wall No. 4 & Roof of Kitchen 1 of First Floor

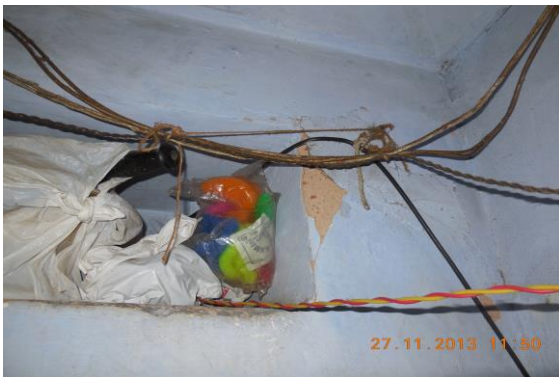
Photo 125

Peeling of Plaster on Wall No. 2 of Kitchen 1 of First Floor

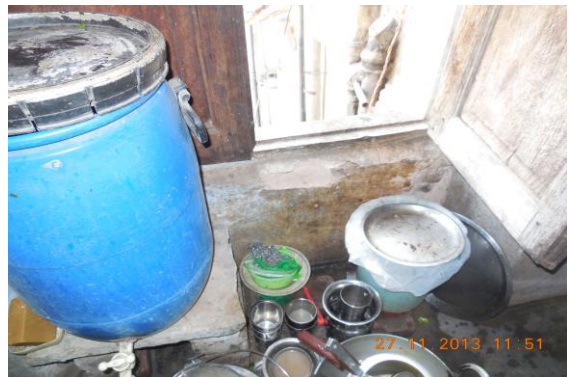
Photo 126

Peeling of Plaster on Wall No. 2 of Kitchen 1 of First Floor

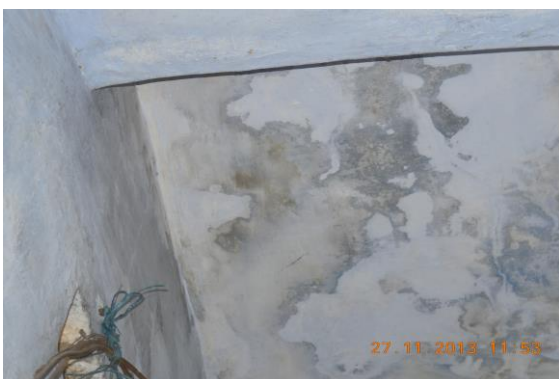
Photo 127

Dampness/Seepage on Roof of Stair 4 of First Floor

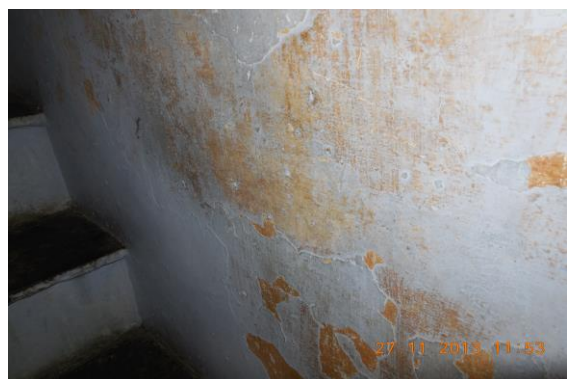
Photo 128

Dampness/Seepage on Wall No. 2 of Stair 4 of First Floor

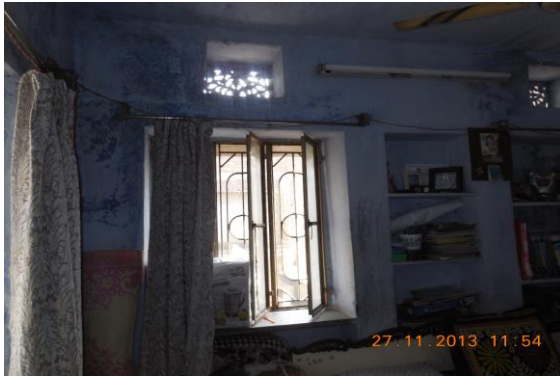
Photo 129

Dampness/Seepage on Wall No. 4 of Room No. 1 of Second Floor

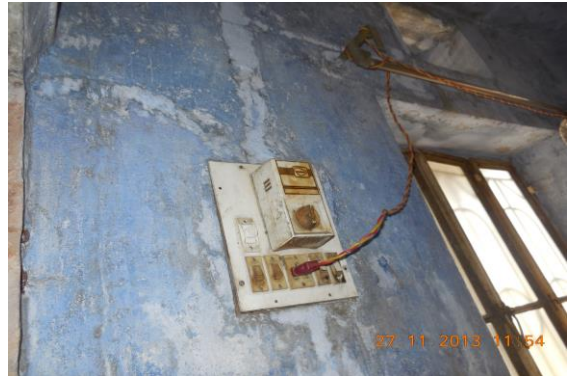
Photo 130

Dampness/Seepage on Wall No. 1 of Room No. 1 of Second Floor

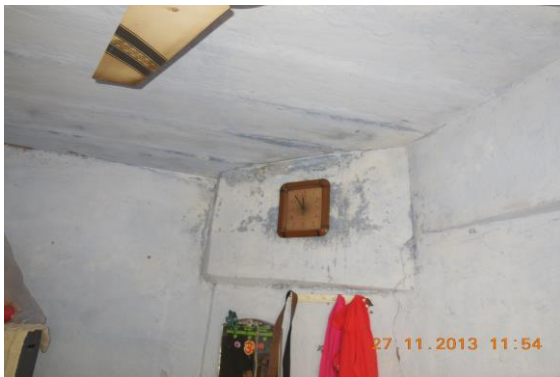
Photo 131

Dampness/Seepage on Wall No. 2 of Room No. 1 of Second Floor

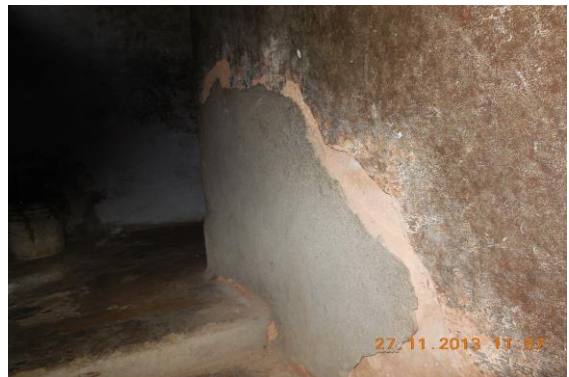
Photo 132

Damaged Portion on Wall No. 2 of Stair 3 of Second Floor

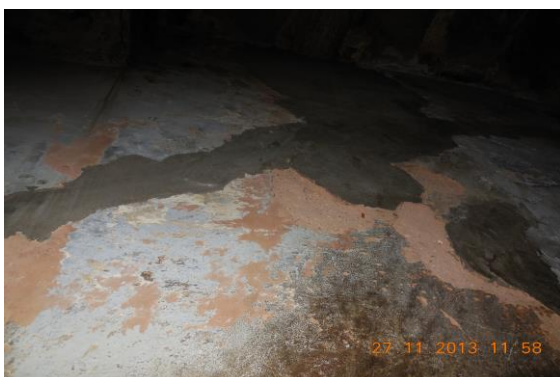
Photo 133

Damaged Portion on Wall No. 1 of Stair 3 of Second Floor

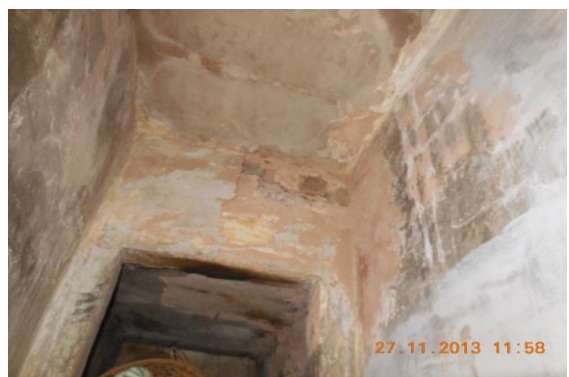
Photo 134

Damaged Portion on Wall No. 3 of Stair 3 of Second Floor

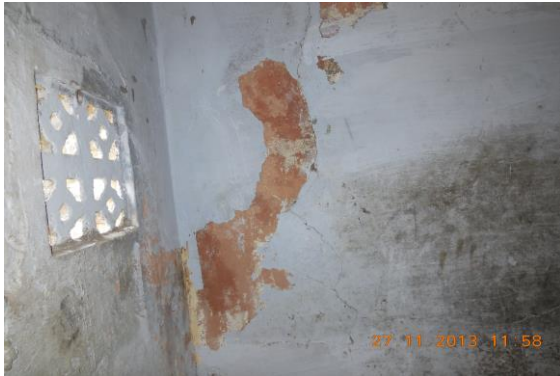
Photo 135  
Peeling of Plaster on Wall No. 4 of Stair 3 of Second Floor

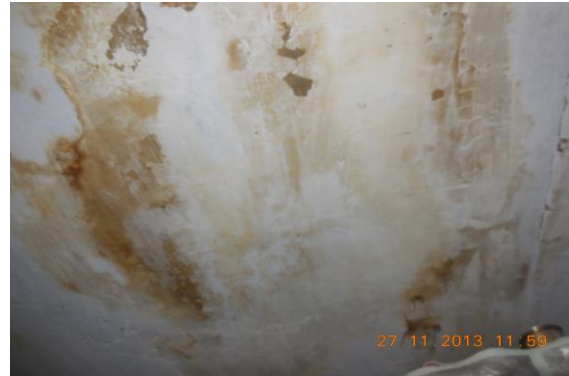
Photo 136  
Dampness/Seepage on Roof of Room No. 1 of Second Floor

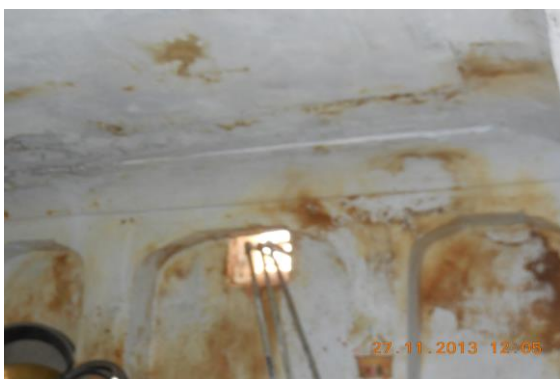
Photo 139  
Dampness/Seepage on Wall No. 1 & Roof of Room No. 2 of Second Floor

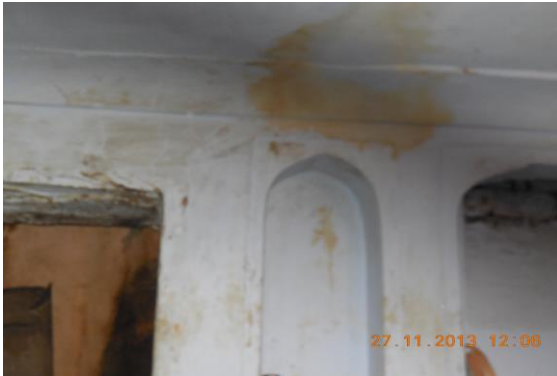
Photo 141

Peeling of Plaster on Wall No. 4 & Roof of Room No. 2 of Second Floor

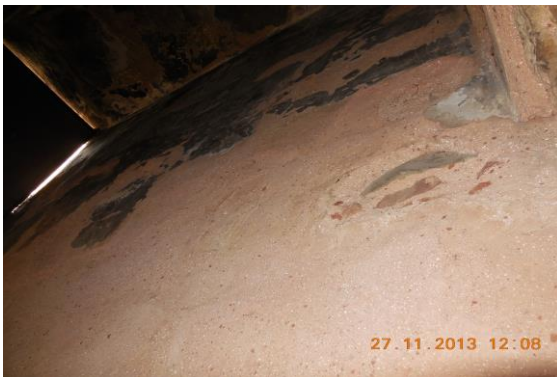
Photo 143

Damaged Portion on Wall No. 1 of Stair 4 of Second Floor
