### Pre Building Condition Survey Report

Name and Address of Structure :	Badi Chopar to Ramp Area (UP Line)
---------------------------------	------------------------------------

Name of the Project	<b>Contract JMRC-UG1B</b> “Design and Construction of Tunnel between Chandpole and Badi Chouper and reverse line by Shield TBM, Underground Metro Stations at Choti Chouper and Badi Chouper by Cut and Cover Methods on East West Corridor of Jaipur Metro Rail Corporation Limited .”	
Owner :

Pre Building Condition Survey Report Badi Chopar to Ramp Area (UP Line)

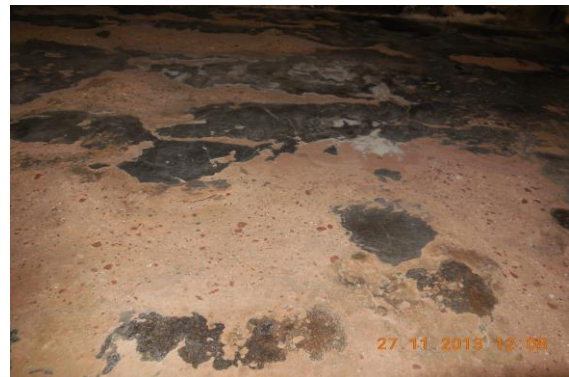
Photo 144

Damaged Portion on Wall No. 2 of Stair 4 of Second Floor

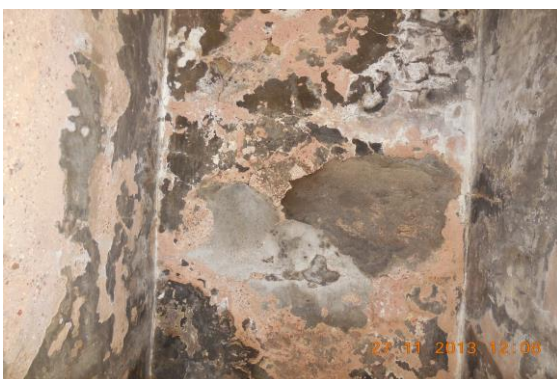
Photo 145

Damaged Portion on Roof of Stair 4 of Second Floor

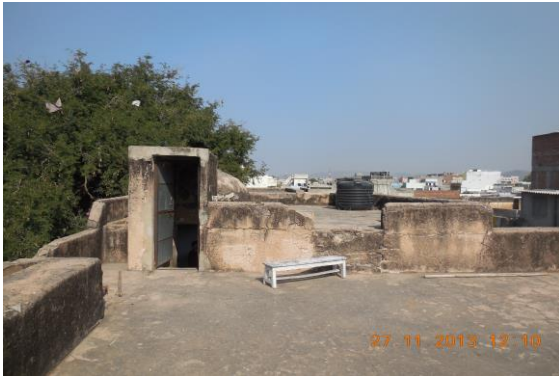
Photo 147  
Damaged Portion on Floor of Terrace of Second Floor

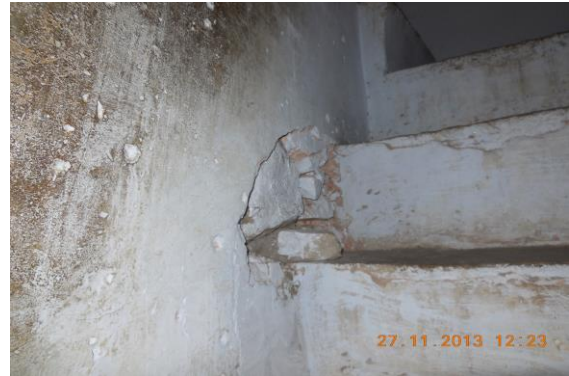
Photo 148  
Damaged Portion on Wall No. 2 of Stair Gf To Ff of Ground Floor

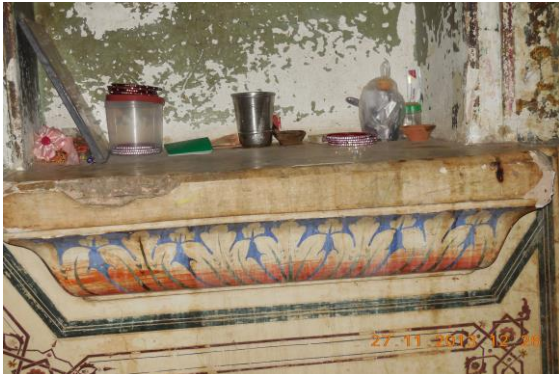
Photo 149  
Peeling of Plaster on Wall No. 1 of Room No. 1 of Ground Floor

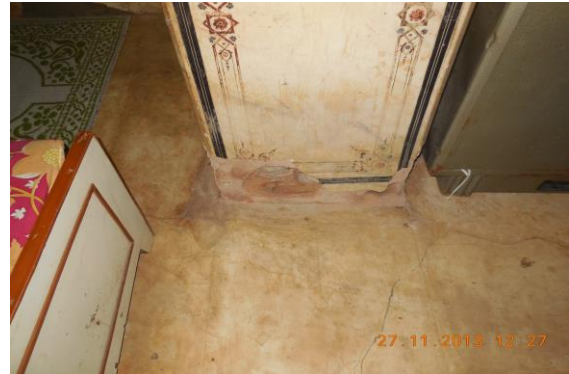
Photo 150  
Peeling of Plaster on Wall No. 1 of Room No. 2 of Ground Floor

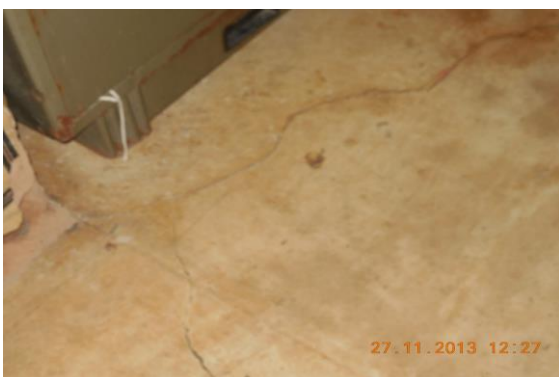
Photo 151  
Damaged Portion on Floor of Room No. 2 of Ground Floor

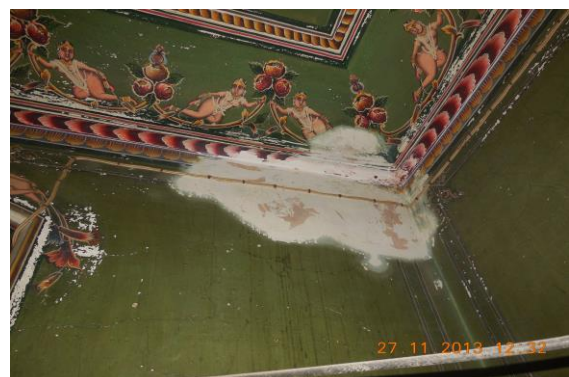
Photo 152  
Dampness/Seepage on Wall No. 2 of Room No. 2 of Ground Floor

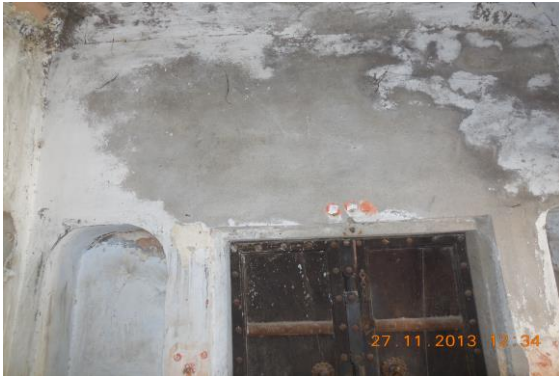
Photo 153  
Peeling of Plaster on Wall No. 1 of Varanda 2 of Ground Floor

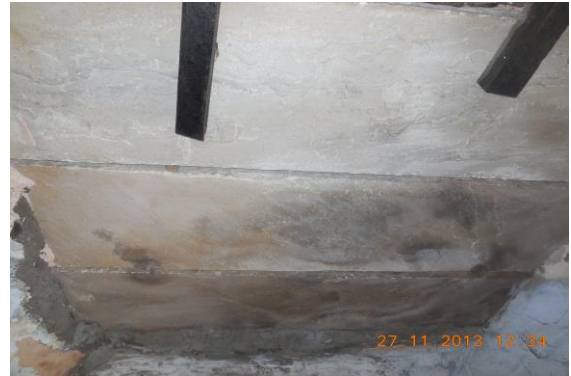
Photo 154  
Damaged Portion on Roof of Varanda 2 of Ground Floor

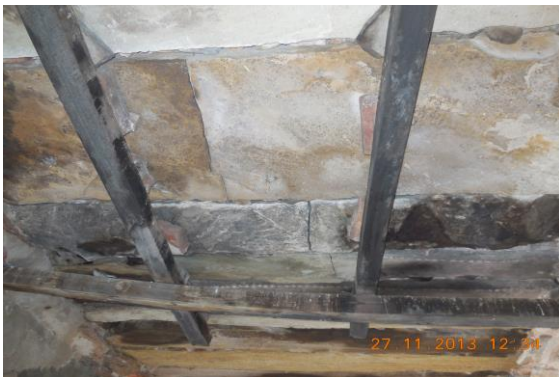
Photo 155  
Damaged Portion on Roof of Varanda 2 of Ground Floor

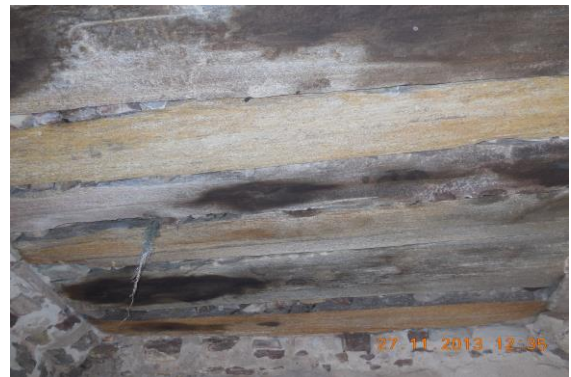
Photo 156  
Damaged Portion on Roof of Varanda 2 of Ground Floor

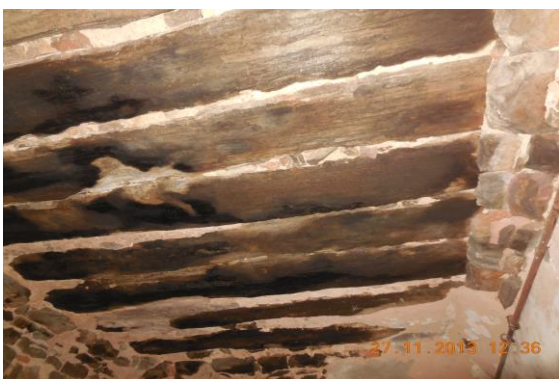
Photo 157  
Damaged Portion on Roof of Varanda 1 of Ground Floor

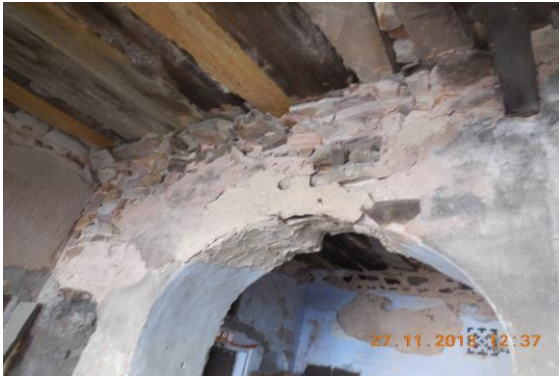
Photo 159

Damaged Portion on Wall No. 2, 3 & 4 of Varanda 2 of Ground Floor

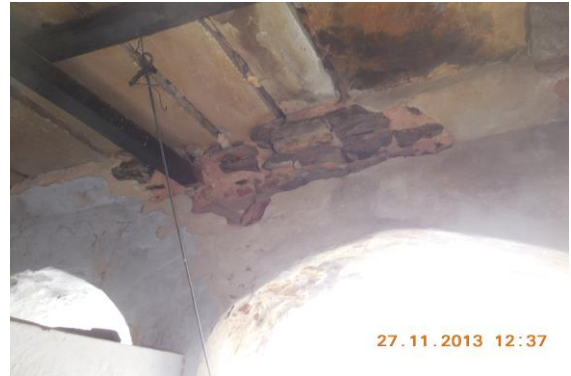
Photo 160

Damaged Portion on Wall No. 2, 3 & 4 of Varanda 2 of Ground Floor

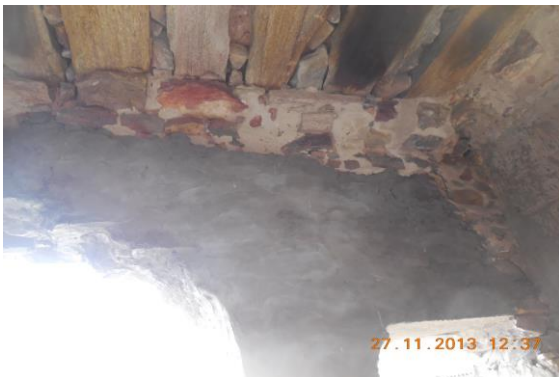
Photo 161

Damaged Portion on Wall No. 2, 3 & 4 of Varanda 2 of Ground Floor

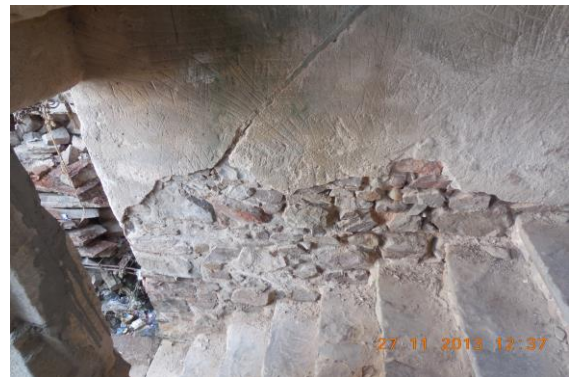
Photo 162

Damaged Portion on Wall No. 2, 3 & 4 of Varanda 2 of Ground Floor

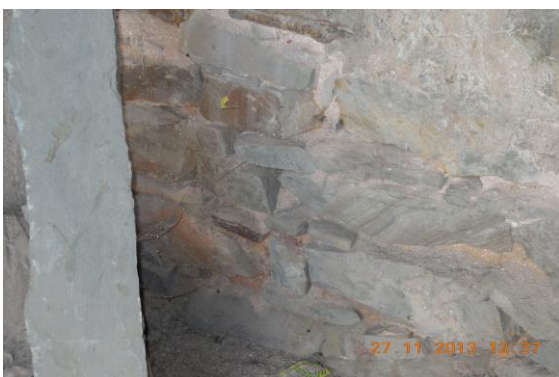
Photo 163

Damaged Portion on Wall No. 2, 3 & 4 of Varanda 2 of Ground Floor

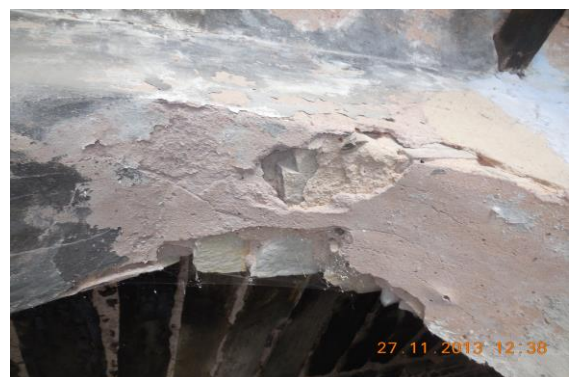
Photo 164

Damaged Portion on Wall No. 2, 3 & 4 of Varanda 2 of Ground Floor

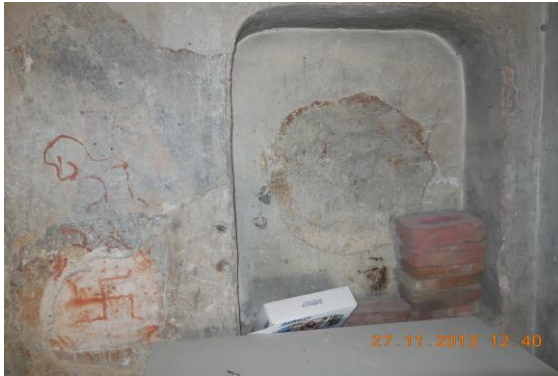
Photo 165

Damaged Portion on All Walls of Varanda of Ground Floor

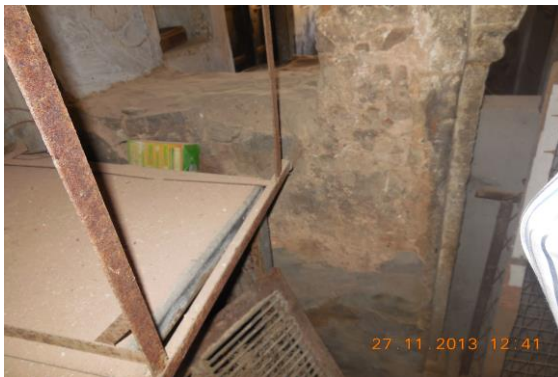
Photo 167

Damaged Portion on All Walls of Varanda of Ground Floor

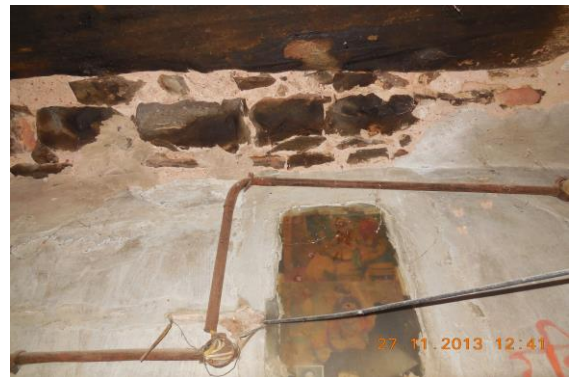
Photo 168

Damaged Portion on All Walls of Varanda of Ground Floor

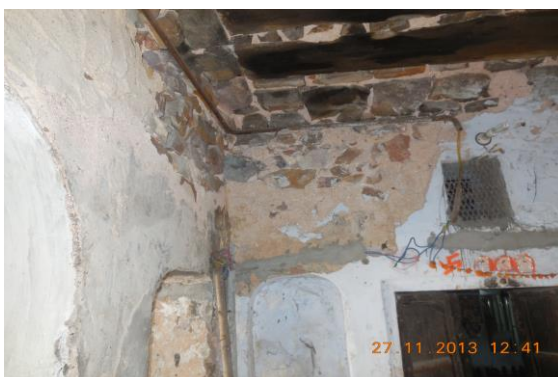
Photo 169

Damaged Portion on All Walls of Varanda of Ground Floor

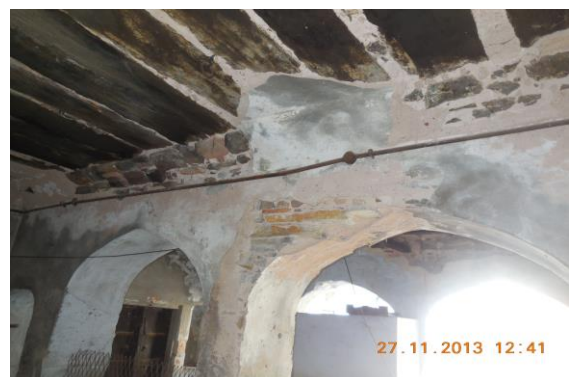
Photo 170

Damaged Portion on All Walls of Varanda of Ground Floor

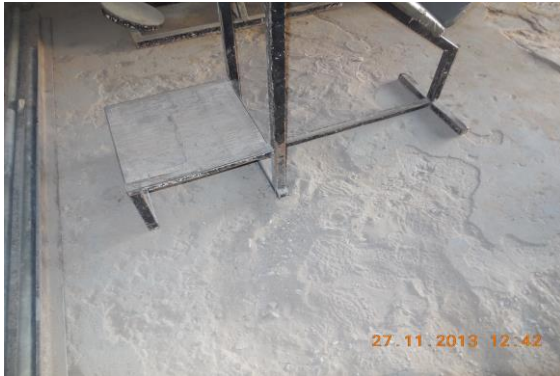
Photo 171  
Damaged Portion on Floor of Varanda 1 of Ground Floor

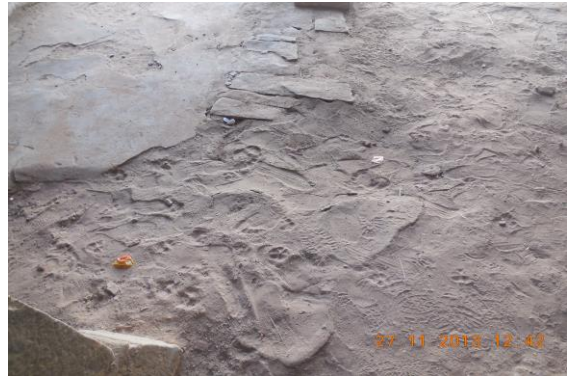
Photo 172  
Damaged Portion on Floor of Varanda 2 of Ground Floor

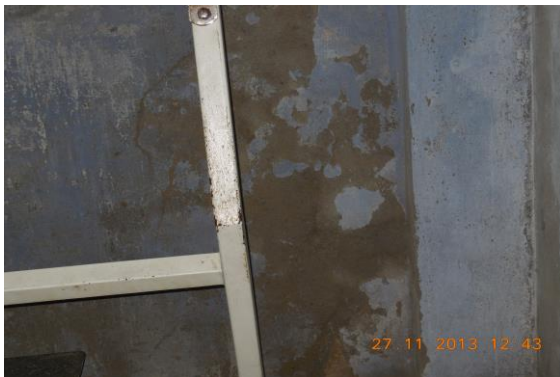
Photo 173  
Dampness/Seepage on Wall No. 1 of Hall No. 1 of Ground Floor

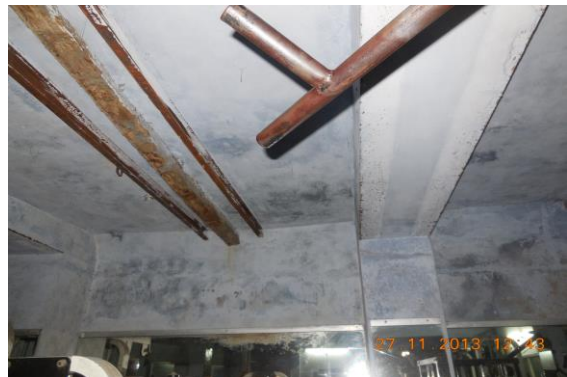
Photo 174  
Dampness/Seepage on Wall No. 2 & Roof of Hall No. 1 of Ground Floor

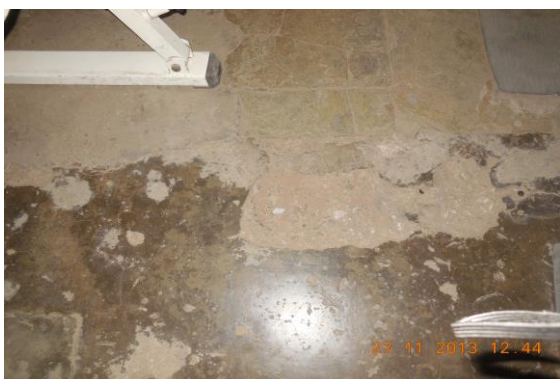
Photo 175  
Damaged Portion on Floor of Hall No. 1 of Ground Floor

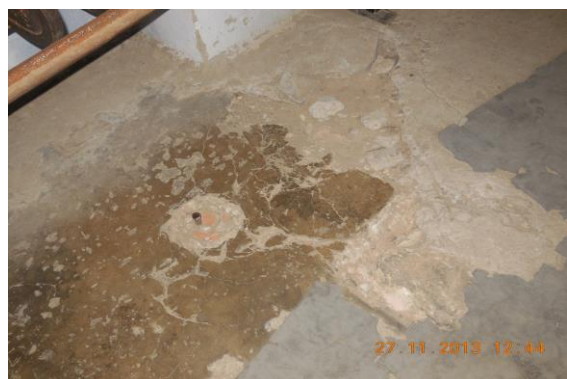
Photo 176  
Damaged Portion on Floor of Hall No. 1 of Ground Floor

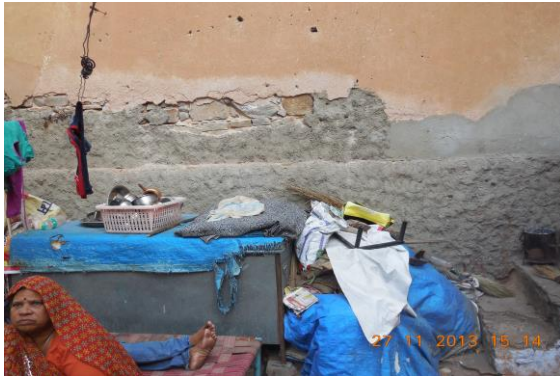
Photo 177  
Damaged Portion on External Façade

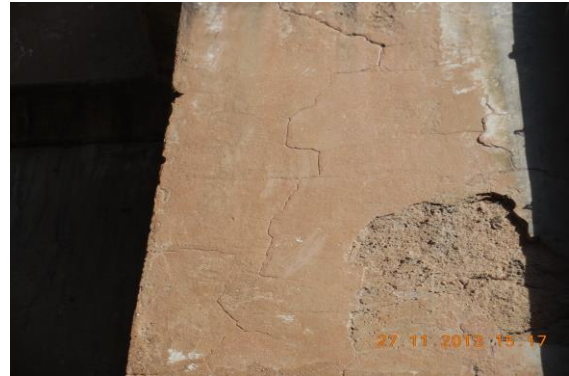
Photo 178  
Damaged Portion on Wall No. 1 of External Façade

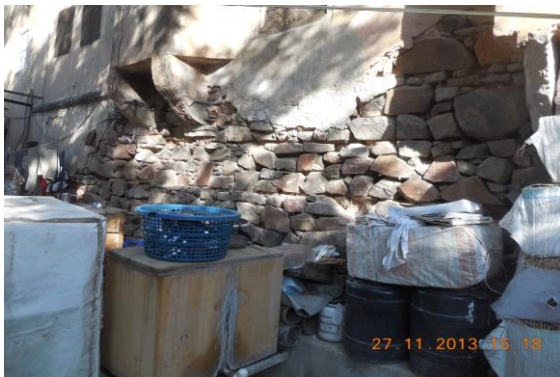
Photo 179  
Damaged Portion on Wall No. 1 of External Façade

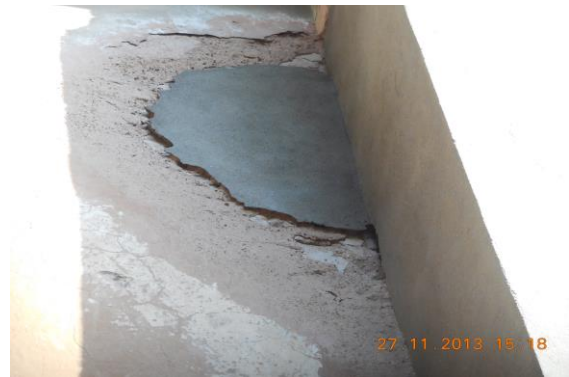
Photo 180  
Damaged Portion on Wall No. 1 of External Façade

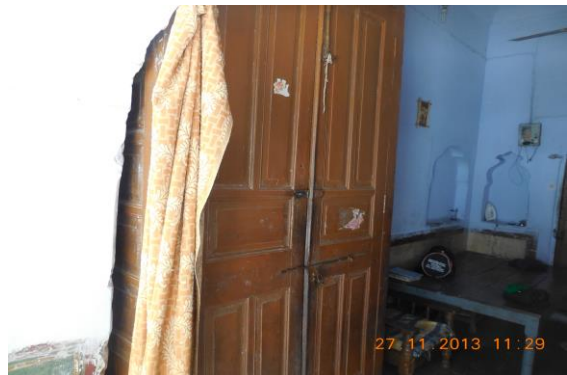
Photo 204  
Wall No. 1 of Room No. 1 of First Floor Covered With Almira

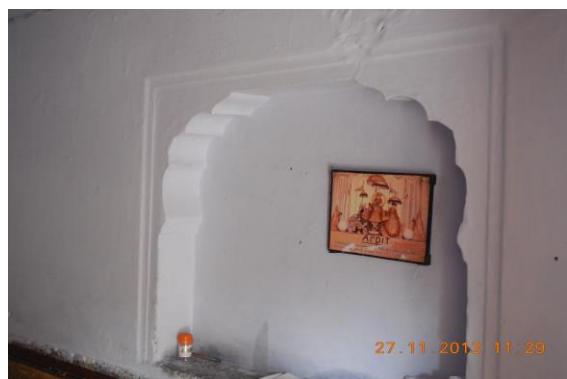
Photo 206  
Wall No. 2 of Room No. 1 of First Floor Covered with Material

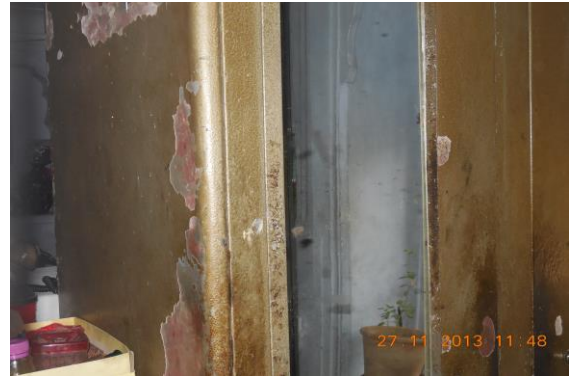
Photo 208

Wall No. 3 of Room No. 3 of First Floor Covered With Almira

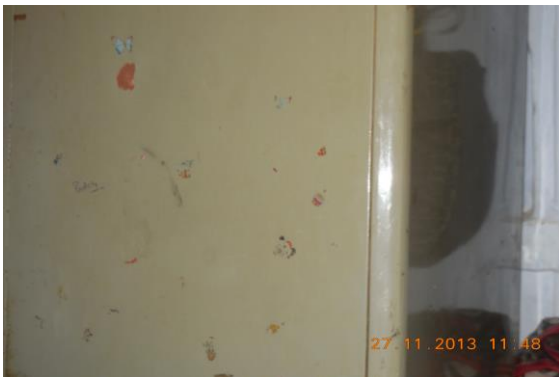
Photo 209

Wall No. 4 of Room No. 3 of First Floor Covered With Almira

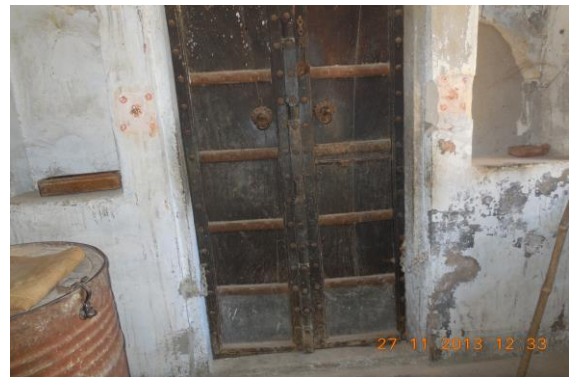
Photo 210

Room No. 3 of Ground Floor Locked

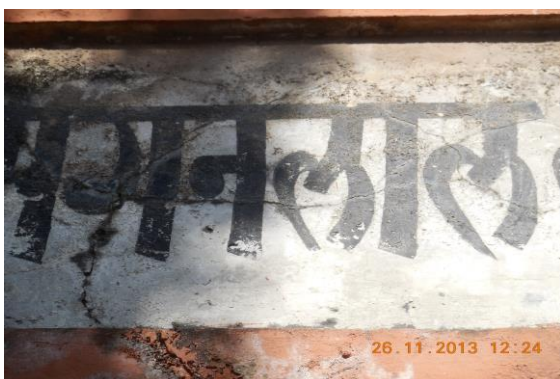
Photo 5  
Inclined Crack on Outer Wall & Leftside External Wall of Varanda of Shop no.349, Ground Floor Approx. Width = 0.35mm, Approx. Length = 1.3m. Distance from Leftside External Column = 0m, Height from Floor = 2.8m

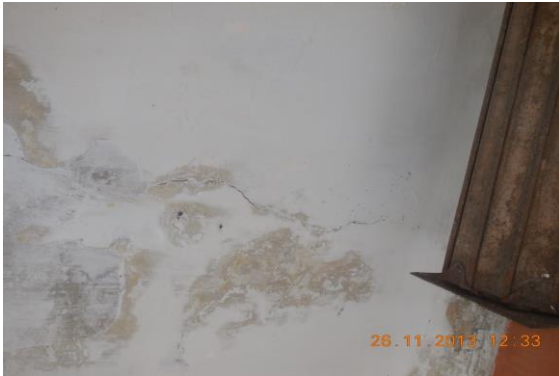
Photo 7

Horizontal Crack on Roof of Varanda of Shop No. 346, Ground Floor  
Approx. Width = 0.5mm, Approx. Length = 1m. Distance from Leftside  
External Column = 0.5m, Height from Floor = 3m.

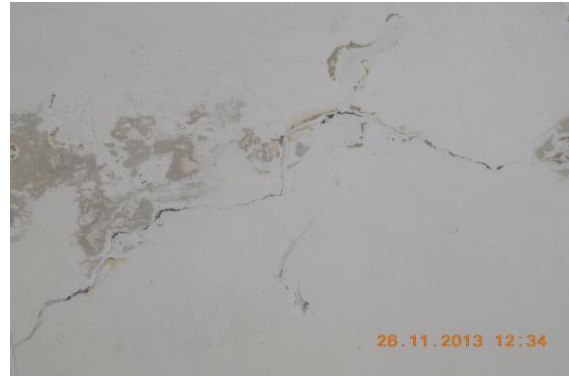
Photo 8

Horizontal Crack on Roof of Varanda of Shop No. 346, Ground Floor  
Approx. Width = 0.15mm, Approx. Length = 1.7m. Distance from  
Rightside External Column = 1.3m, Height from Floor = 3m.

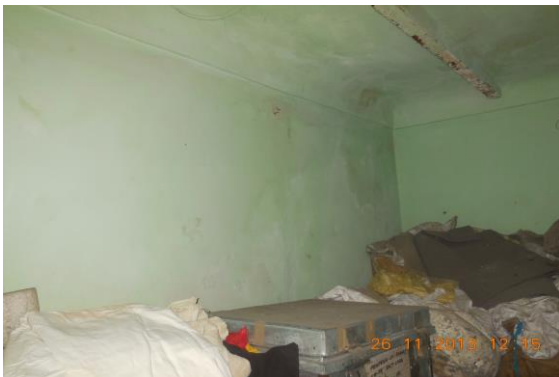
Photo 9

Dampness/Seepage on Wall No. 1 & Roof of Part B of Shop no. 349 of  
Ground Floor

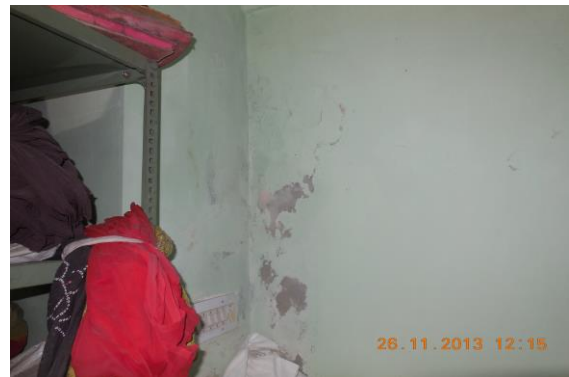
Photo 10

Peeling of Plaster on Wall No. 3 of Part B of Shop no. 349 of Ground  
Floor

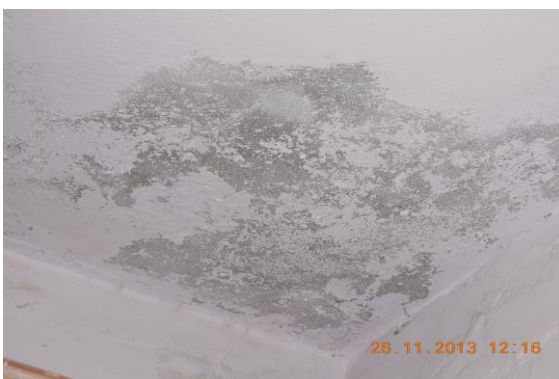
Photo 11

Dampness/Seepage on Roof of Part A of Shop no. 349 of Ground Floor

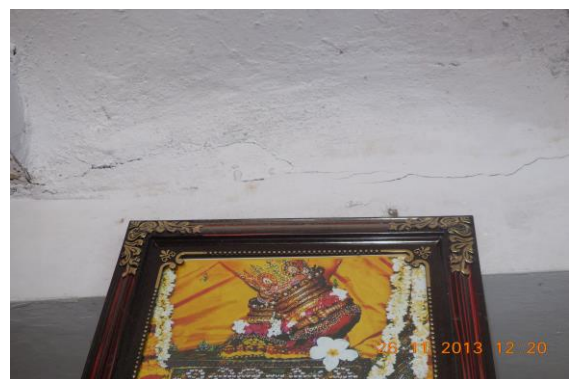
Photo 12

Peeling of Plaster on Wall No. 4 of Part A of Shop no. 349 of Ground  
Floor

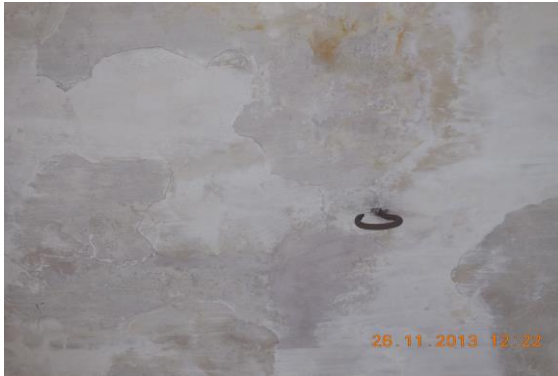
Photo 13

Dampness/Seepage on Roof of Part A of Shop no.349 of Ground Floor

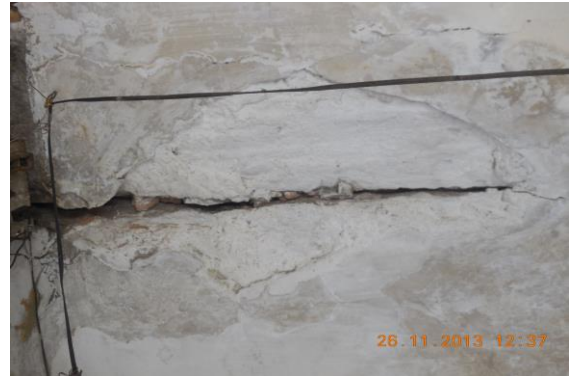
Photo 14

Damaged Portion on Roof of Varanda of Shop No.346 of Ground Floor

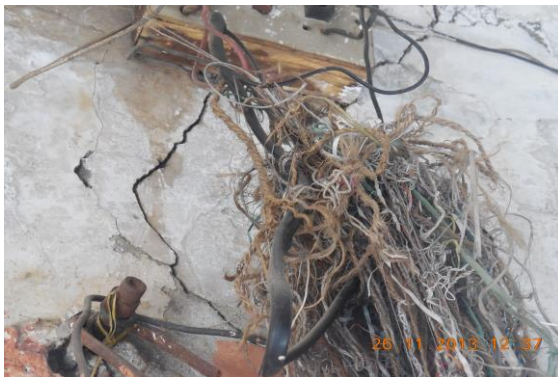
Photo 15

Damaged Portion on Rightside External Beam of Varanda of Shop No.346 of Ground Floor

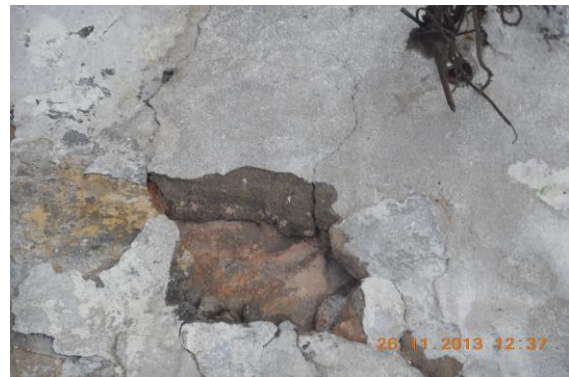
Photo 16

Damaged Portion on Rightside internal Beam of Varanda of Shop No.346 of Ground Floor

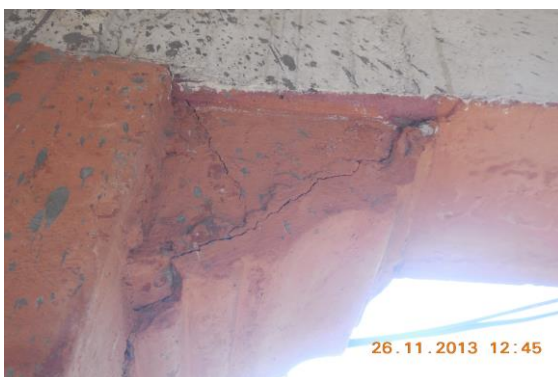
Photo 17

Peeling of Plaster on External Beam & Rightside External Column of Varanda of Shop No.345 of Ground Floor

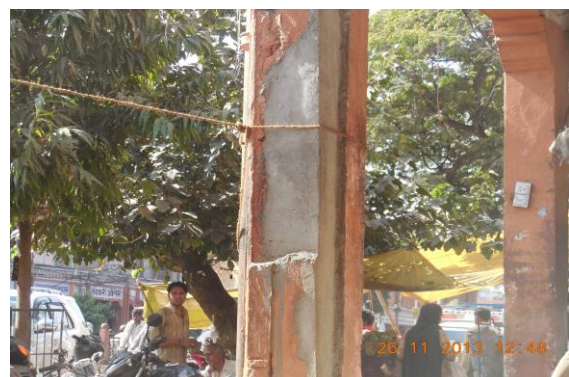
Photo 18

Damaged Portion on Outer Wall & Rightside Column of Varanda of Shop No.345 of Ground Floor

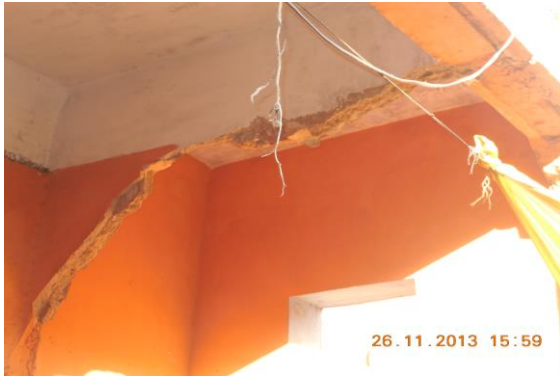
Photo 19

Damaged Portion on Rightside Wall of Varanda of Shop No.345 of Ground Floor

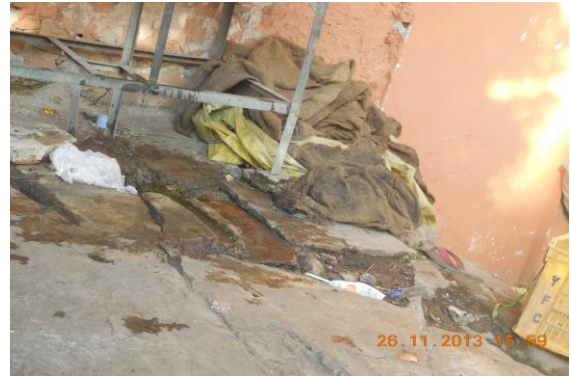
Photo 20

Damaged Portion on Floor of Varanda of Shop No.345 of Ground Floor

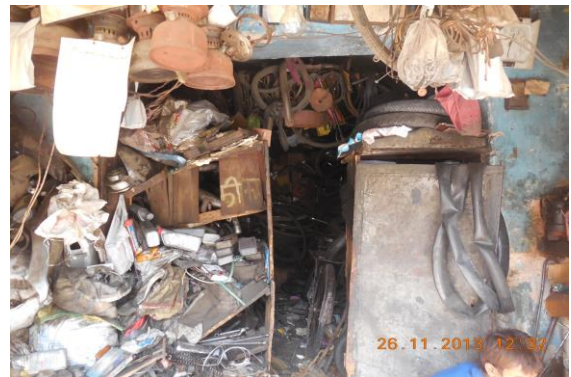
Photo 22

All Walls & Roof of Shop No.346 of Ground Floor Covered With Material

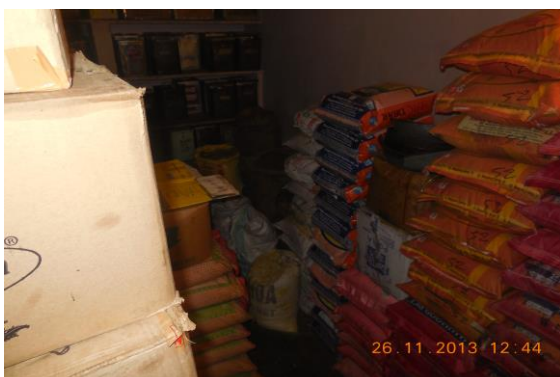
Photo 23

All Walls of Shop No.345 of Ground Floor Covered With Materials

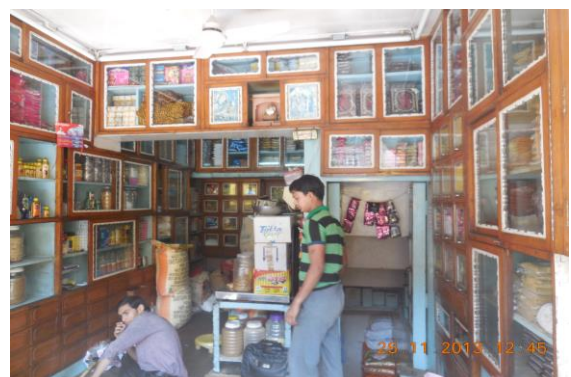
Photo 24

All Walls of Shop No.345 of Ground Floor Covered With Wooden Racks & Materials

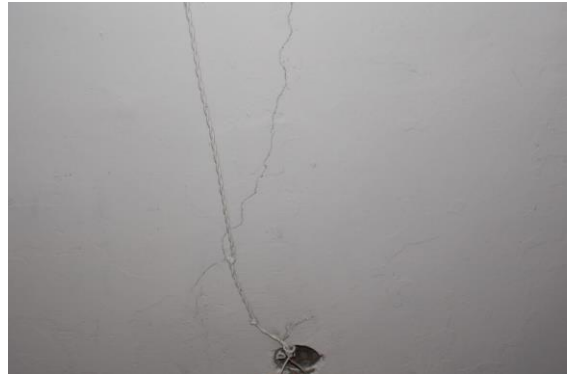
Photo 16  
Inclined Crack on Roof of Shop No.213, Ground floor  
Approx. Width = 0.6mm, Approx. Length = 1.1m.  
Distance from Wall No.2 = 1m, Height from Floor = 2.8m.

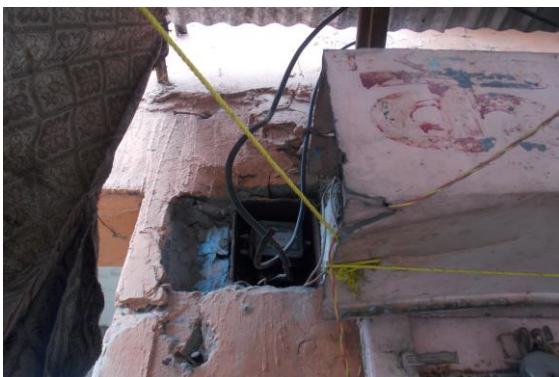
Photo 17  
Damaged Portion on Left side Wall of Outside of Shop No.217, Ground floor

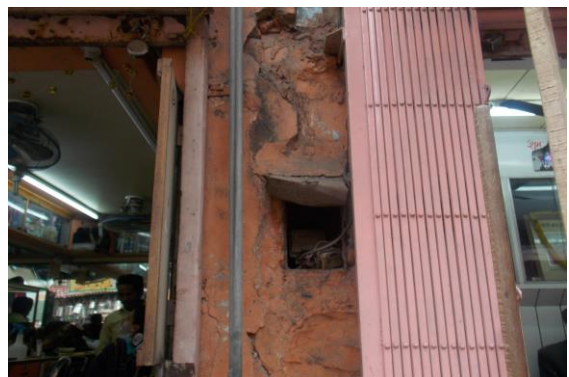
Photo 18  
Damaged Portion on Right side Wall of Outside of Shop No.217, Ground floor

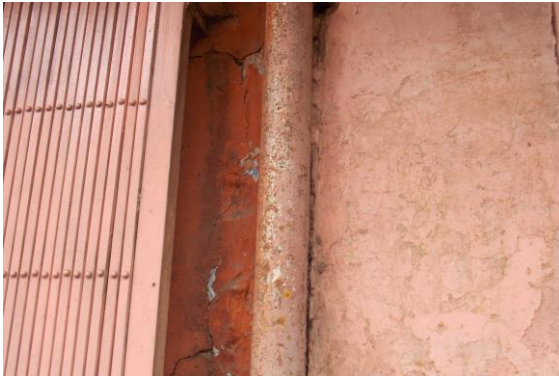
Photo 19

Damaged Portion on Left side Wall of Outside of Shop No.214, Ground floor

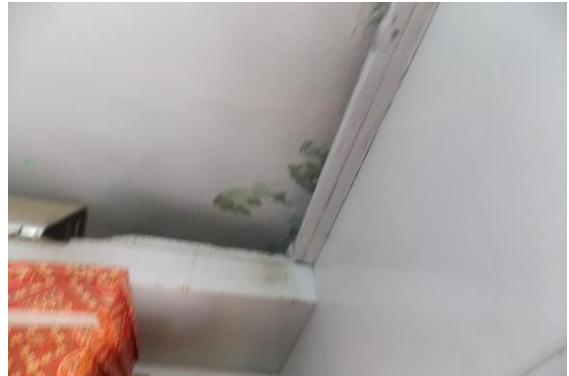
Photo 20

Dampness/Seepage on Roof of Shop No.213 of Ground floor

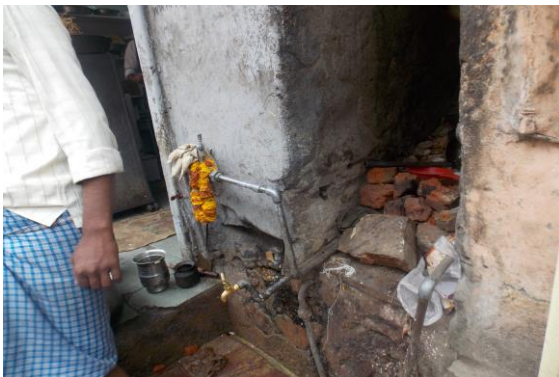
Photo 21

Damaged Portion on Right side Wall of Outside of Shop No.213, Ground floor

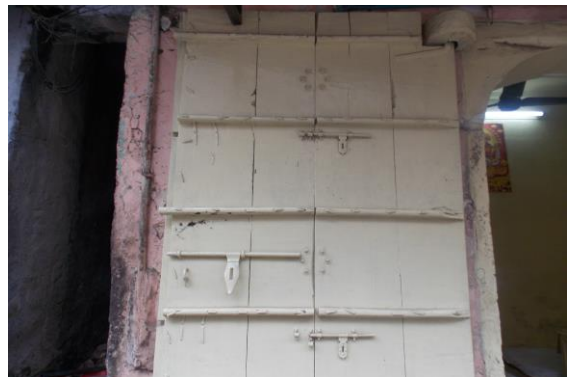
Photo 22

Damaged Portion on Left side Wall of Outside of Shop No.212, Ground floor

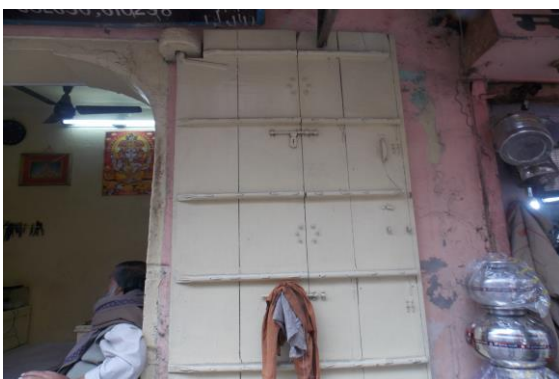
Photo 23

Damaged Portion on Right side Wall of Outside of Shop No.212, Ground floor

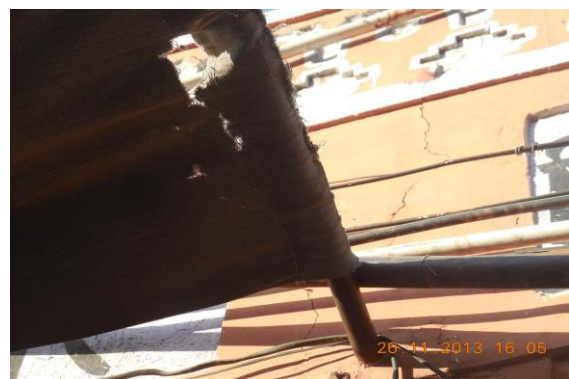
Photo 12  
Inclined Crack on R/s External Column of Varanda of Shop No.343, G/F  
Approx. Width = 0.6mm, Approx. Length = 1.15m. Distance from R/s  
External Column = 0m, Height from Floor = 3m.

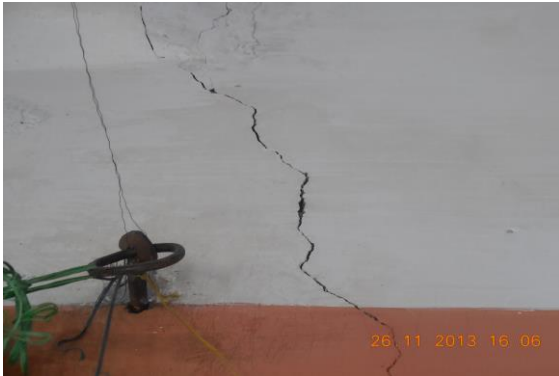
Photo 13

Inclined Crack on R/s External Column of Varanda of Shop No.343, G/F  
Approx. Width = 1mm, Approx. Length = 3.15m. Dist. from R/s External Column = 0m, Height from Floor = 2.8m.

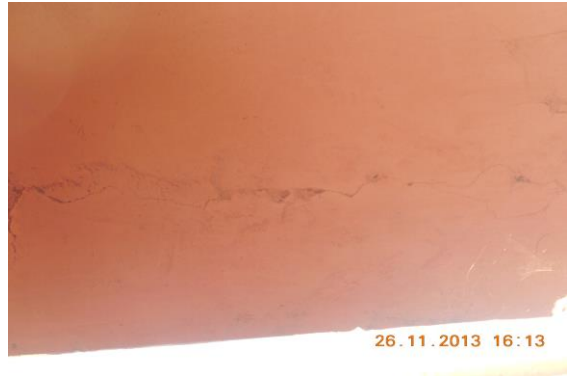
Photo 14

Inclined Crack on External Beam of Varanda of Shop No.343A, G/F  
Approx. Width = 0.35mm, Approx. Length = 1.1m. Distance from Leftside External Beam = 0m, Height from Floor = 3.1m.

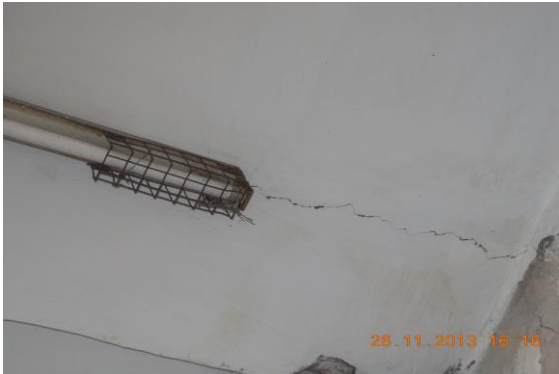
Photo 15

Inclined Crack on Outer Wall, 3 & Roof of Varanda of Shop No.343A, G/F  
Approx. Width = 1.5mm, Approx. Length = 3m. Distance from L/s External Beam = 0m, Height from Floor = 2.9m.

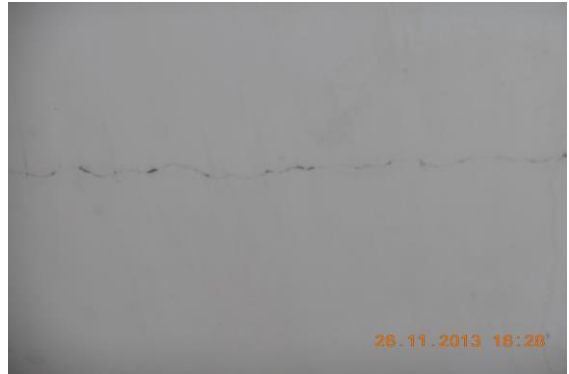
Photo 16

Horizontal Crack on Roof of Varanda of Shop no.342B, G/F  
Approx. Width = 0.5mm, Approx. Length = 2.3m. Distance from Leftside External Column = 0.3m, Height from Floor = 3.5m.

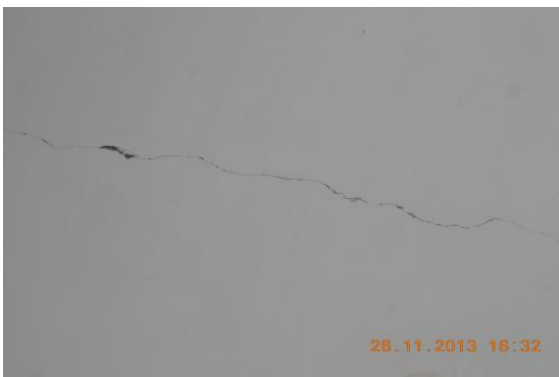
Photo 17

Horizontal Crack on Roof of Varanda of Shop no.342B, Ground Floor  
Approx. Width = 1.5mm, Approx. Length = 2m. Distance from Rightside External Column = 0m, Height from Floor = 3.5m.

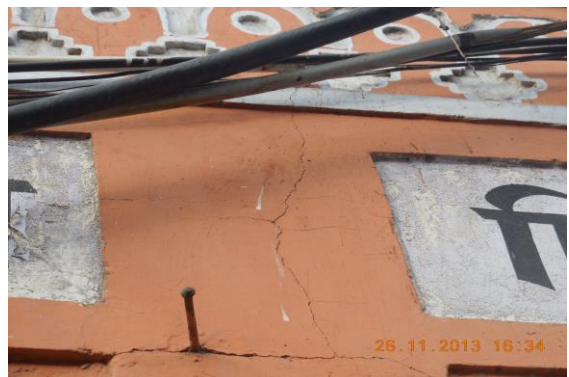
Photo 18

Inclined Crack on R/s External Column of Varanda of Shop no.342B, G/F  
Approx. Width = 0.25mm, Approx. Length = 1.3m. Distance from R/s External Column = 0m, Height from Floor = 3.3m.

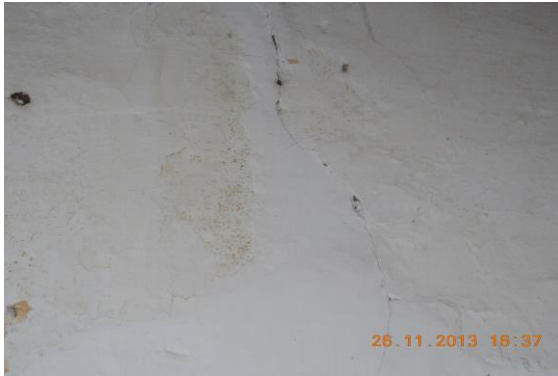
Photo 19

Inclined Crack on Wall No. 4 of Part B of Shop No.342 B, G/F Approx.  
Width = 2.5mm, Approx. Length = 1.5m.  
Distance from Wall No.1 = 0.5m, Height from Floor = 2m.

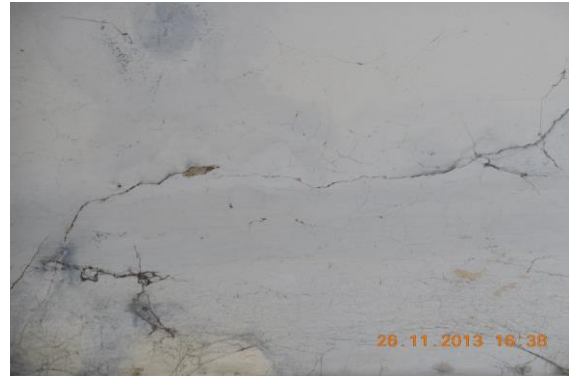
Photo 20

Inclined Crack on Roof of Part A of Shop No.342 B, Ground Floor  
Approx. Width = 0.5mm, Approx. Length = 2.2m.  
Distance from Wall No.1 = 0.6m, Height from Floor = 3m.

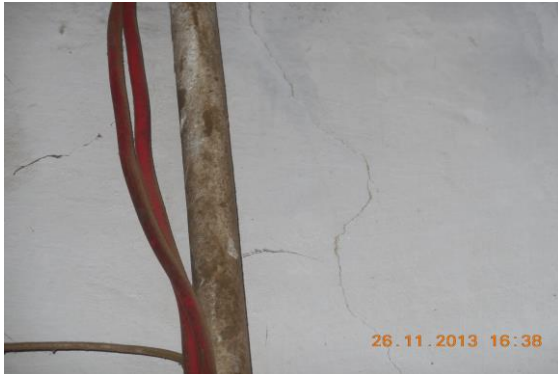
Photo 21

Inclined Crack on Wall No. 2 of Part A of Shop No.342 B, Ground Floor  
Approx. Width = 0.25mm, Approx. Length = 0.4m. Distance from Wall  
No.3 = 0.25m, Height from Floor = 2.3m.

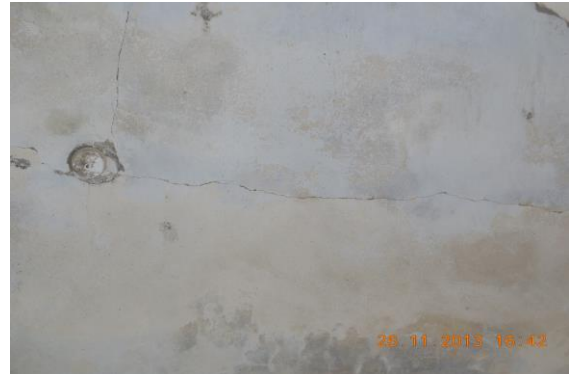
Photo 22

Horizontal Crack on Roof of Varanda of Shop No.341, Ground Floor  
Approx. Width = 1mm, Approx. Length = 2m. Distance from Leftside  
External Column = 1.45m, Height from Floor = 3.5m.

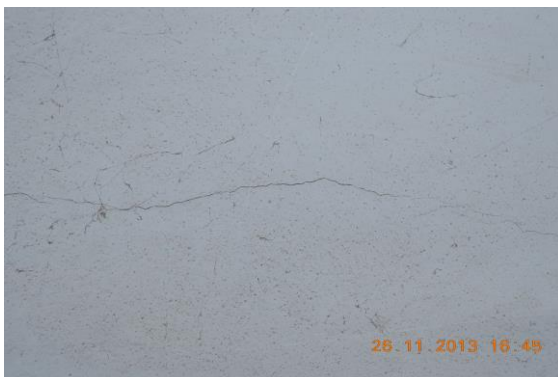
Photo 23

Horizontal Crack on Wall No. 4 of Shop No.341, M.S.Floor Approx.  
Width = 0.4mm, Approx. Length = 0.6m. Distance from Wall No.1 =  
0.1m, Height from Floor = 1.2m.

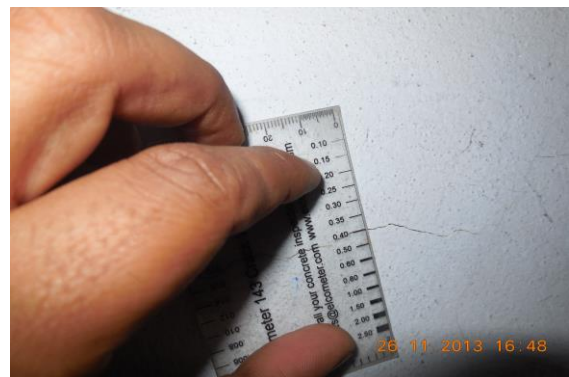
Photo 23A

Horizontal Crack on Wall No. 4 of Shop No.341, M.S.Floor Approx.  
Width = 0.4mm, Approx. Length = 0.6m. Distance from Wall No.1 =  
0.1m, Height from Floor = 1.2m.

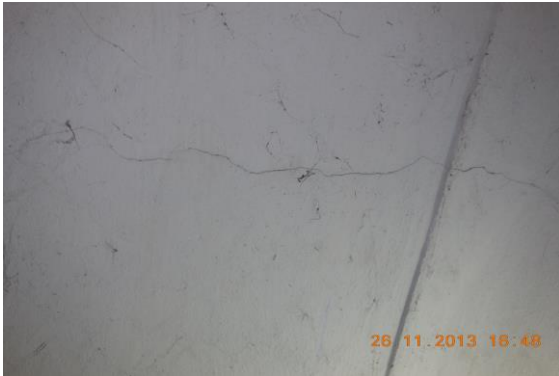
Photo 24

Horizontal Crack on Wall No. 4 & Roof of Shop No.341, M.S.Floor  
Approx. Width = 0.3mm, Approx. Length = 0.8m. Distance from Wall No.2 = 0.4m, Height from Floor = 1.6m.

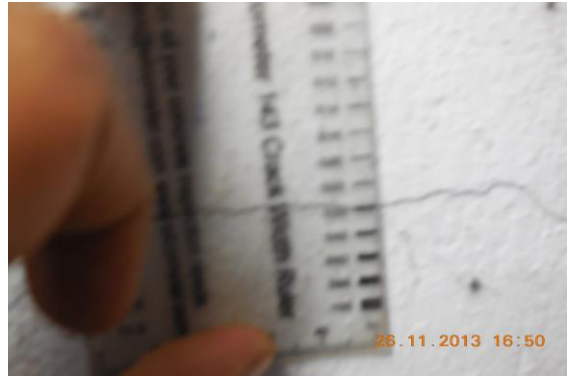
Photo 24A

Horizontal Crack on Wall No. 4 & Roof of Shop No.341, M.S.Floor  
Approx. Width = 0.3mm, Approx. Length = 0.8m. Distance from Wall No.2 = 0.4m, Height from Floor = 1.6m.

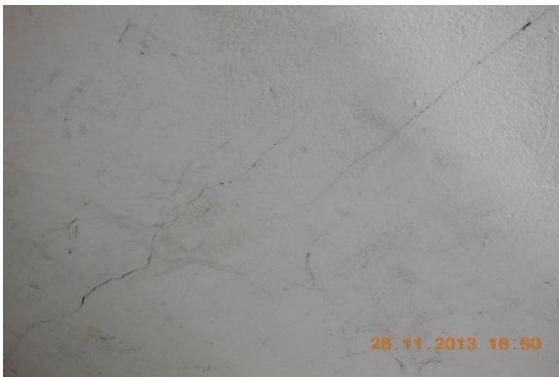
Photo 25

Horizontal Crack on Roof of Shop No.341, M.S.Floor Approx. Width = 0.3mm, Approx. Length = 0.4m. Distance from Wall No.2 = 0.5m, Height from Floor = 1.8m.

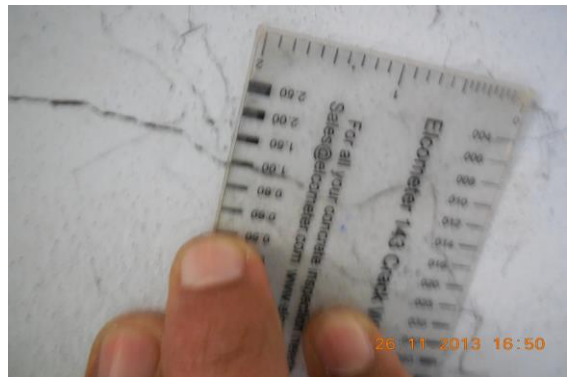
Photo 25A

Horizontal Crack on Roof of Shop No.341, M.S.Floor Approx. Width = 0.3mm, Approx. Length = 0.4m. Distance from Wall No.2 = 0.5m, Height from Floor = 1.8m.

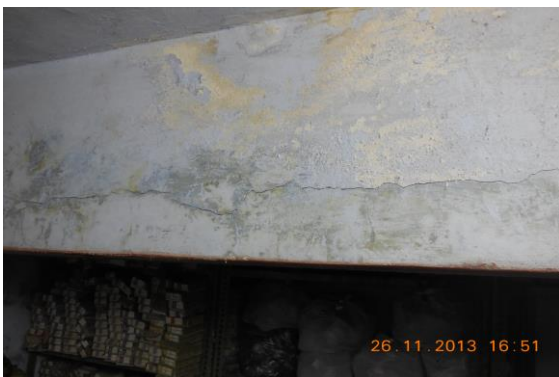
Photo 26

Horizontal Crack on Roof Beam of Shop No.341, M.S.Floor Approx. Width = 0.3mm, Approx. Length = 2.3m. Distance from Wall No.3 = 0m, Height from Floor = 1.8m.

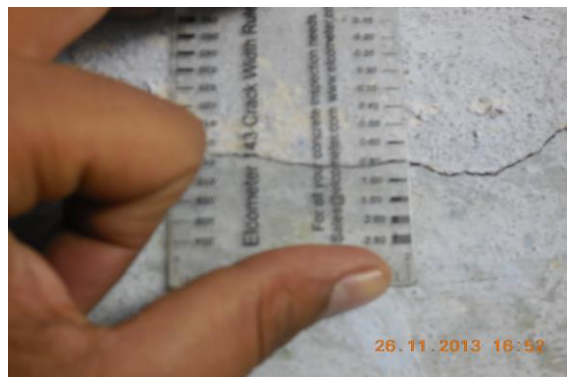
Photo 26A

Horizontal Crack on Roof Beam of Shop No.341, M.S.Floor  
Approx. Width = 0.3mm, Approx. Length = 2.3m.  
Distance from Wall No.3 = 0m, Height from Floor = 1.8m.

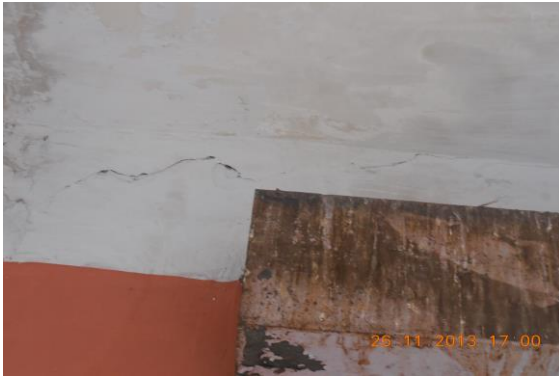
Photo 27

Horizontal Crack on Wall No. 4 of Varanda of Shop No.340, G/F Approx.  
Width = 0.15mm, Approx. Length = 1.1m. Distance from Leftside  
External Column = 0m, Height from Floor = 3.4m.

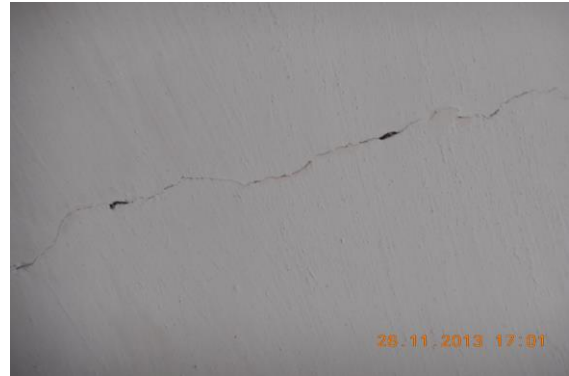
Photo 28

Horizontal Crack on Roof of Varanda of Shop No.340, Ground Floor  
Approx. Width = 0.15mm, Approx. Length = 2m. Distance from  
Rightside External Column = 0.7m, Height from Floor = 3.5m.

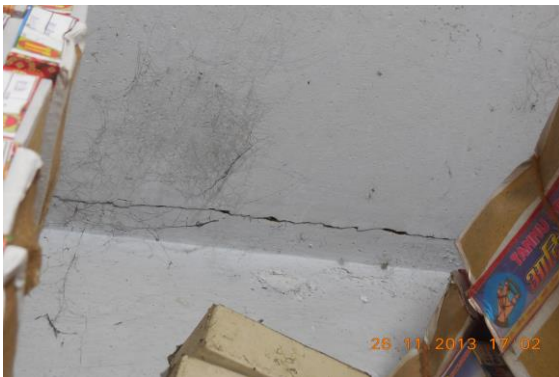
Photo 29

Horizontal Crack on Roof of Part A of Shop No.340, Ground Floor  
Approx. Width = 1mm, Approx. Length = 2m. Distance from Wall No.3 =  
0m, Height from Floor = 3m.

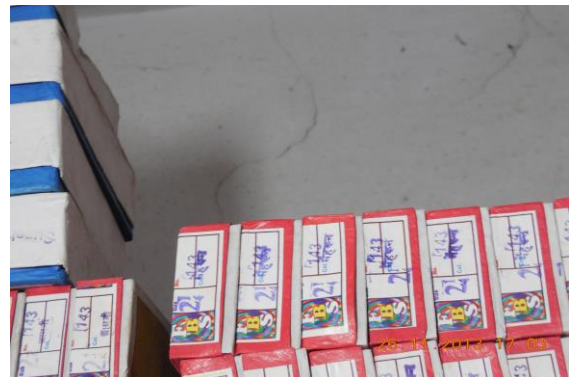
Photo 30

Inclined Crack on Wall No. 1 of Part A of Shop No.340, Ground Floor  
Approx. Width = 0.2mm, Approx. Length = 0.7m. Distance from Wall  
No.3 = 0.6m, Height from Floor = 2.3m.

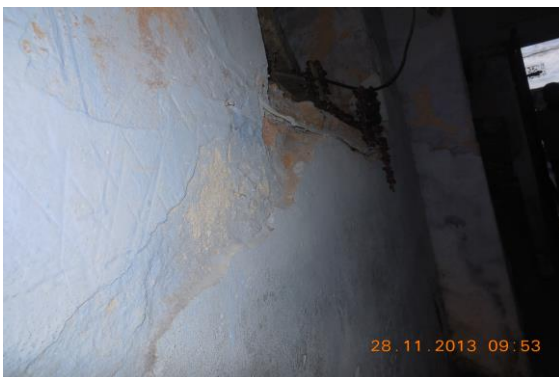
Photo 30A

Inclined Crack on Wall No. 1 of Part A of Shop No.340, Ground Floor  
Approx. Width = 0.2mm, Approx. Length = 0.7m. Distance from Wall  
No.3 = 0.6m, Height from Floor = 2.3m.

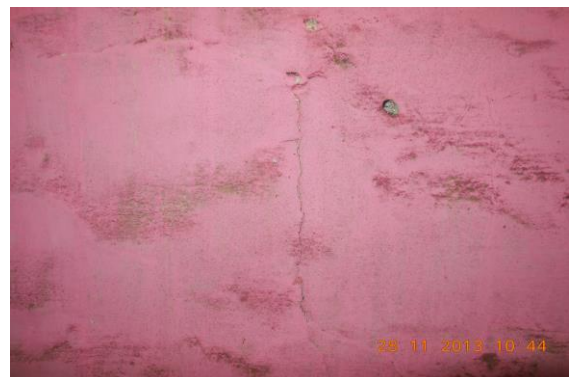
Photo 31

Inclined Crack on Wall No. 2 of Room No. 1, House No. 1902, Second  
Floor Approx. Width = 0.8mm, Approx. Length = 2.1m. Distance from w3  
= 0.1m, Height from Floor = 0m.

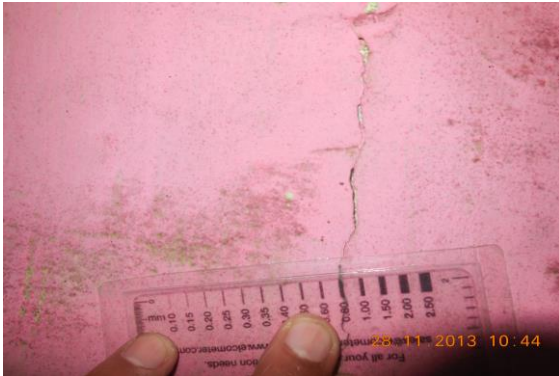
Photo 31A

Inclined Crack on Wall No. 2 of Room No. 1, House No. 1902, Second Floor Approx. Width = 0.8mm, Approx. Length = 2.1m. Distance from w3 = 0.1m, Height from Floor = 0m.

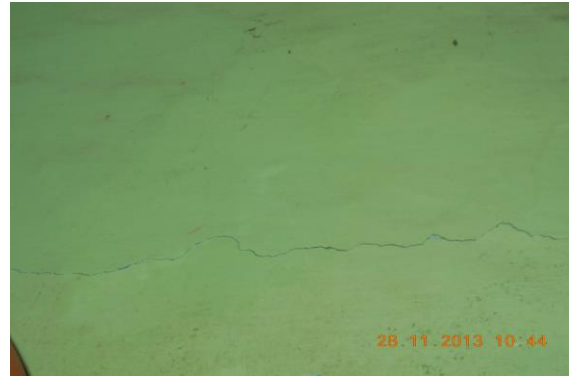
Photo 32

Inclined Crack on Wall No. 2 of Room No. 1, House No. 1902, Second Floor Approx. Width = 0.5mm, Approx. Length = 0.7m. Distance from w4 = 0.4m, Height from Floor = 2m.

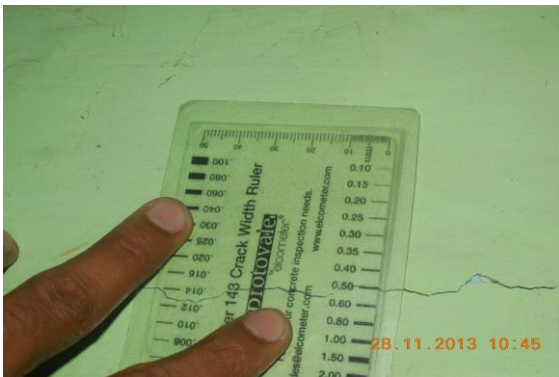
Photo 32A

Inclined Crack on Wall No. 2 of Room No. 1, House No. 1902, Second Floor Approx. Width = 0.5mm, Approx. Length = 0.7m. Distance from w4 = 0.4m, Height from Floor = 2m.

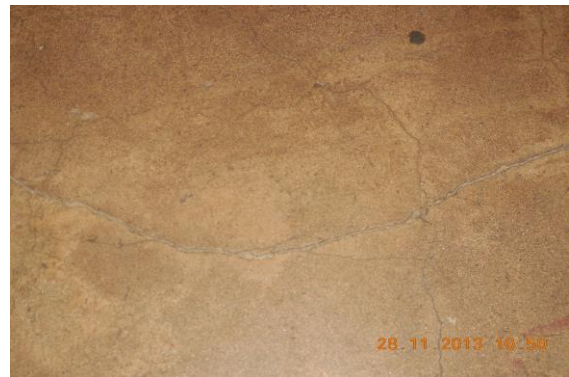
Photo 33

Horizontal Crack on Floor of Room No. 1, House No. 1902, Second Floor Approx. Width = 1.5mm, Approx. Length = 1.7m. Distance from Wall No. 2 = 0.3m, Height from Floor = 0m.
