### Pre Building Condition Survey Report

Name and Address of Structure :	Badi Chopar to Ramp Area (UP Line)
---------------------------------	------------------------------------

Name of the Project	<b>Contract JMRC-UG1B</b> “Design and Construction of Tunnel between Chandpole and Badi Chouper and reverse line by Shield TBM, Underground Metro Stations at Choti Chouper and Badi Chouper by Cut and Cover Methods on East West Corridor of Jaipur Metro Rail Corporation Limited .”	
Owner :

Pre Building Condition Survey Report Badi Chopar to Ramp Area (UP Line)

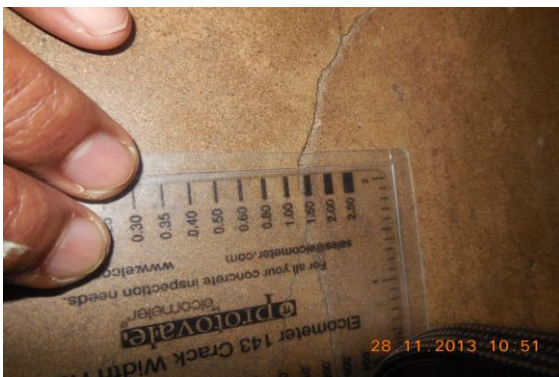
Photo 33A

Horizontal Crack on Floor of Room No. 1, House No. 1902, Second Floor Approx. Width = 1.5mm, Approx. Length = 1.7m. Distance from Wall No. 2 = 0.3m, Height from Floor = 0m.

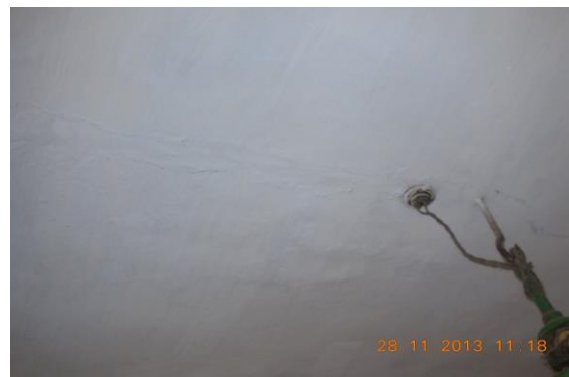
Photo 34

Horizontal Crack on Roof of Varanda, House No. 1902, Upper First Floor Approx. Width = 0.35mm, Approx. Length = 2m. Distance from Wall No. 1 = 2.5m, Height from Floor = 2.7m.

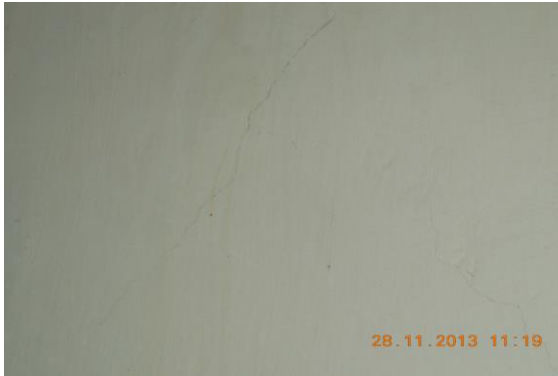
Photo 35

Inclined Crack on Wall No. 4 of Varanda 1, House No. 1902, Upper First Floor Approx. Width = 0.1mm, Approx. Length = 1.3m. Distance from Wall No. 1 = 2.7m, Height from Floor = 1.5m.

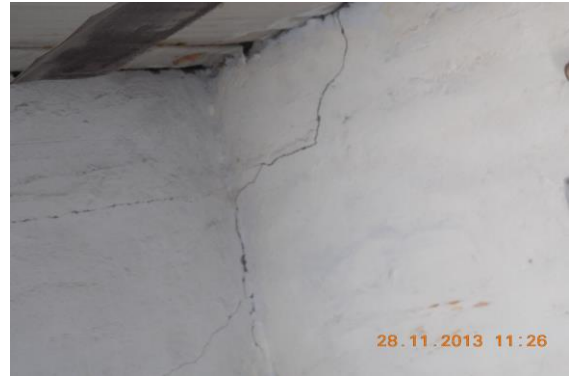
Photo 36

Inclined Crack on Wall No. 1 of Room No. 1, House No. 1902, Upper First Floor Approx. Width = 0.8mm, Approx. Length = 4.2m. Distance from w3 = 2m, Height from Floor = 0m.

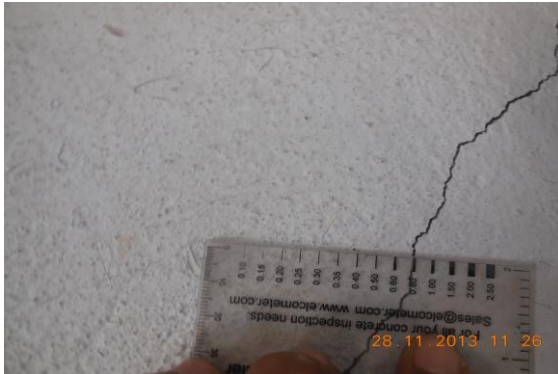
Photo 36A

Inclined Crack on Wall No. 1 of Room No. 1, House No. 1902, Upper First Floor Approx. Width = 0.8mm, Approx. Length = 4.2m. Distance from w3 = 2m, Height from Floor = 0m.

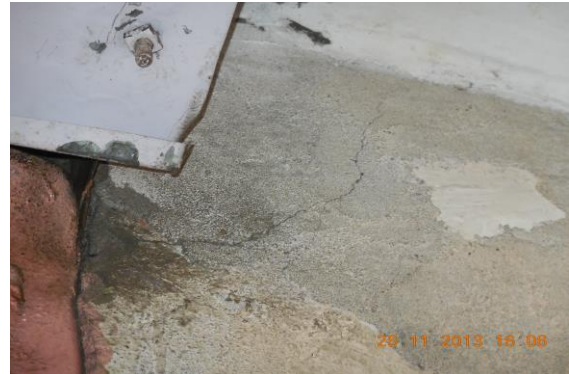
Photo 37

Damaged Portion on Outer Wall of Varanda of Shop No.343 of Ground Floor

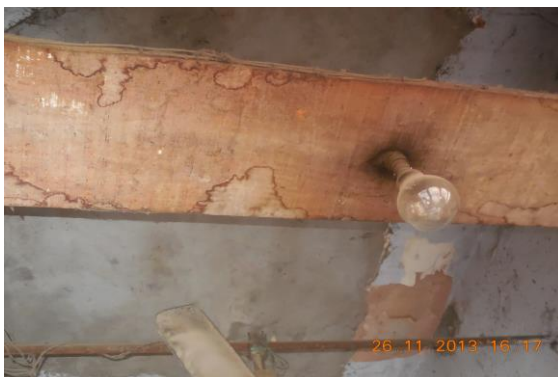
Photo 38

Peeling of Plaster on Roof of Part A of Shop No.343A of Ground Floor

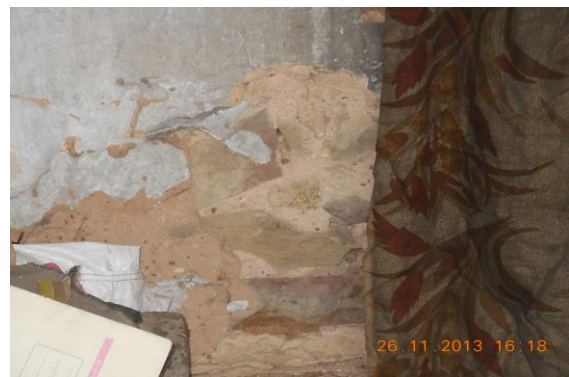
Photo 39

Peeling of Plaster on Wall No. 4 of Part A of Shop No.343A of Ground Floor

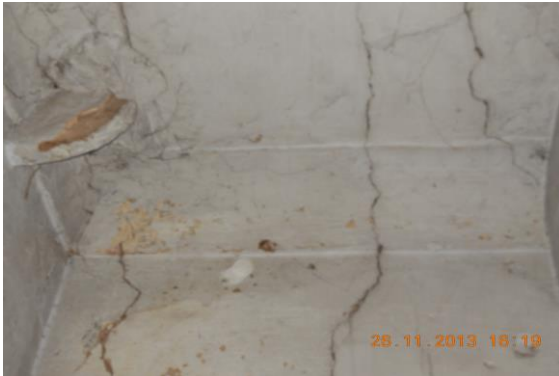
Photo 40

Damaged Portion on Wall No. 3, 4 & Roof of Part B of Shop No.343A of Ground Floor

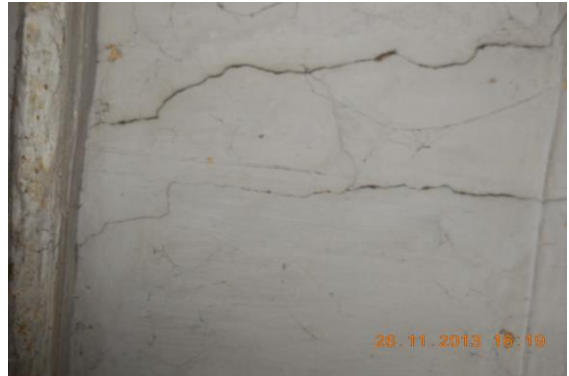
Photo 41

Damaged Portion on Wall No. 3, 4 & Roof of Part B of Shop No.343A of Ground Floor

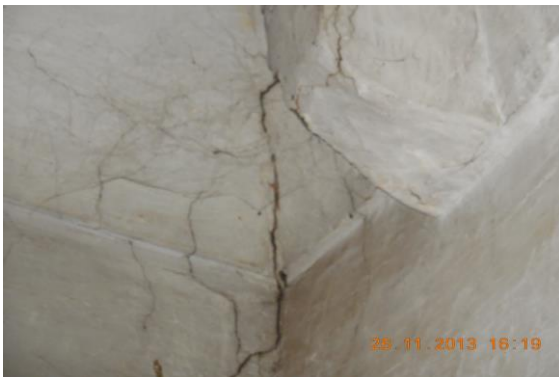
Photo 42

Damaged Portion on Wall No. 3, 4 & Roof of Part B of Shop No.343A of Ground Floor

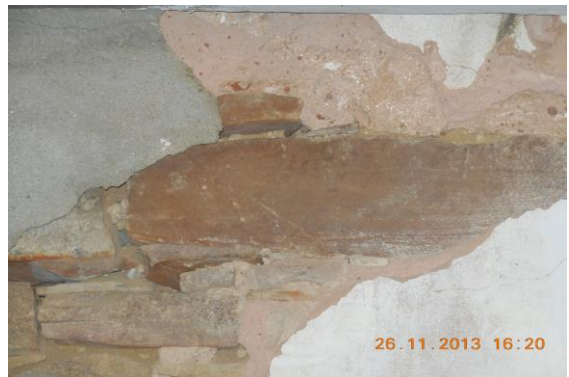
Photo 43

Damaged Portion on Wall No. 4 of Part C of Shop No.343A of Ground Floor

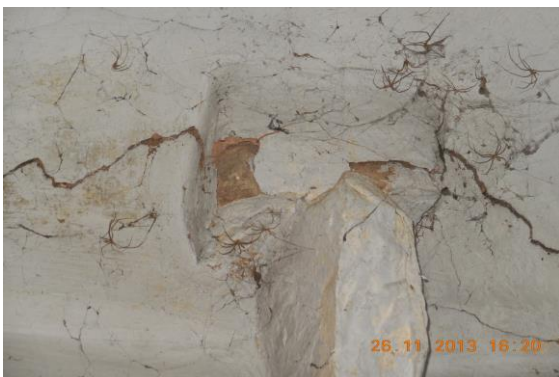
Photo 44

Damaged Portion on Roof of Part C of Shop No.343A of Ground Floor

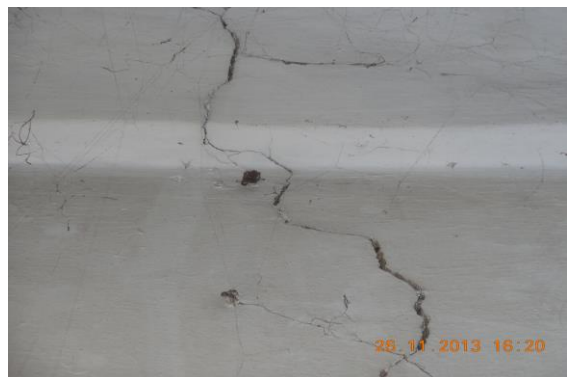
Photo 45

Damaged Portion on Wall No. 3 of Part C of Shop No.343A of Ground Floor

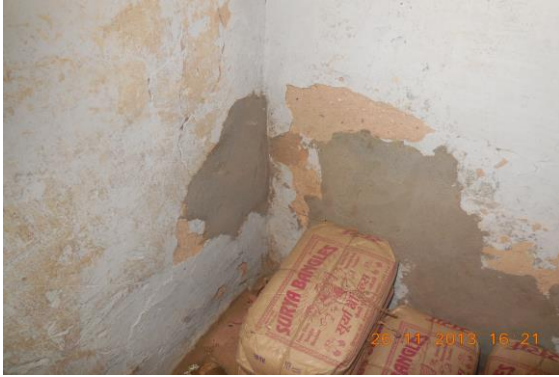
Photo 46

Peeling of Plaster on Wall No. 1 & 3 of Part C of Shop No.343A of Ground Floor

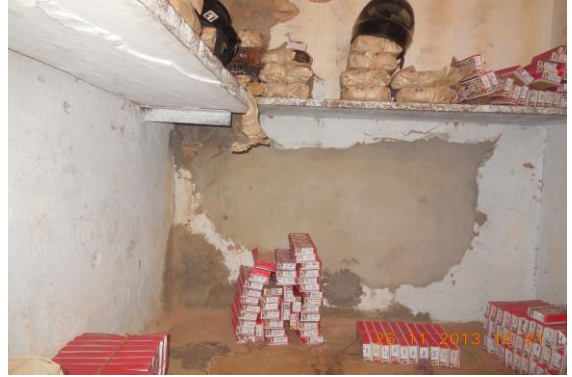
Photo 47

Peeling of Plaster on Wall No. 4 of Part C of Shop No.343A of Ground Floor

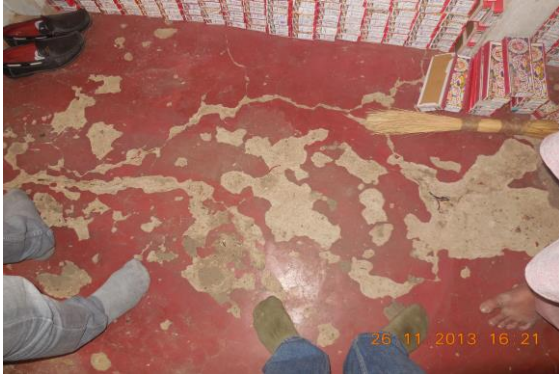
Photo 48

Damaged Portion on Roof of Part B of Shop No.343A of Ground Floor

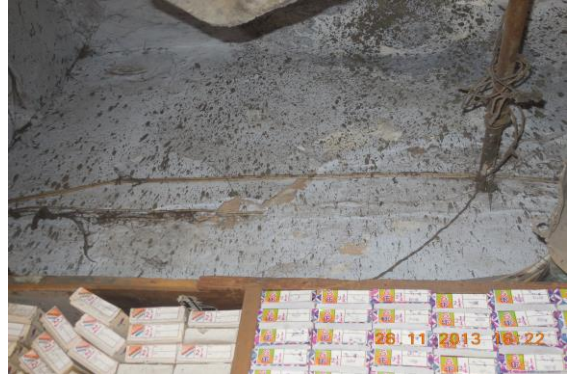
Photo 49

Damaged Portion on Wall No. 1 of Part A of Shop No.343A of Ground Floor

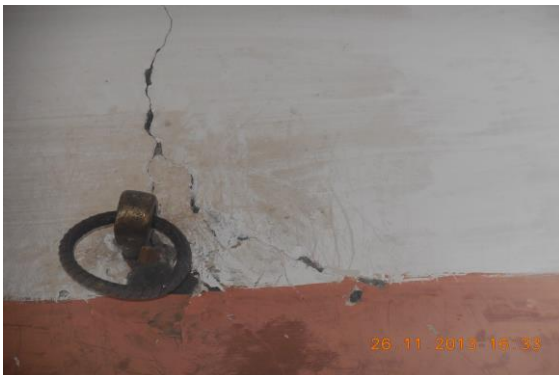
Photo 50

Damaged Portion on External Beam of Varanda of Shop no.342B of Ground Floor

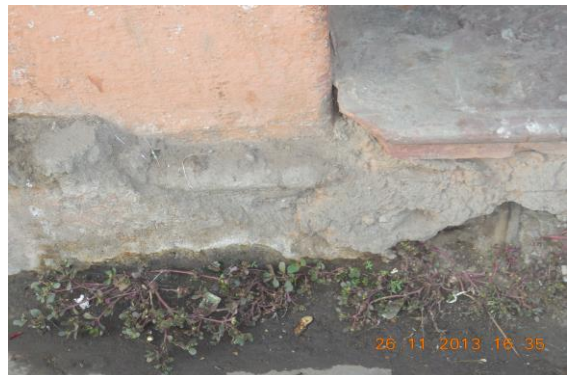
Photo 51

Damaged Portion on Floor of Varanda of Shop no.342B of Ground Floor

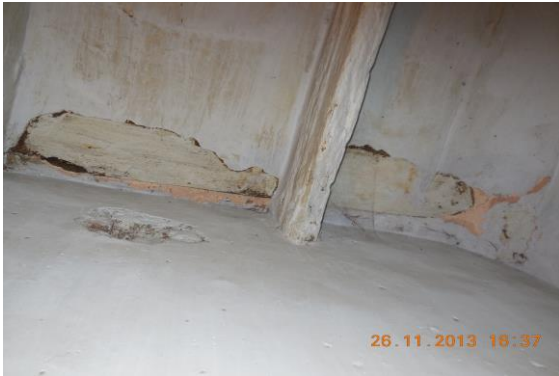
Photo 52

Damaged Portion on Roof of Part C of Shop No.342 B of Ground Floor

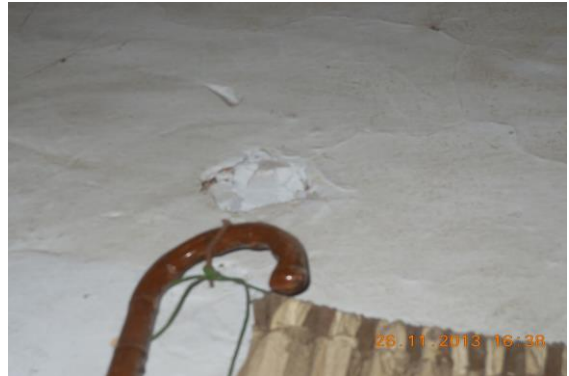
Photo 53

Peeling of Plaster on Wall No. 3 of Part B of Shop No.342 B of Ground Floor

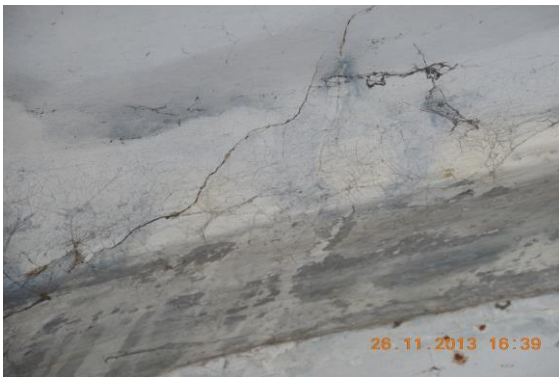
Photo 54

Dampness/Seepage on Roof of Part A of Shop No.342 B of Ground Floor

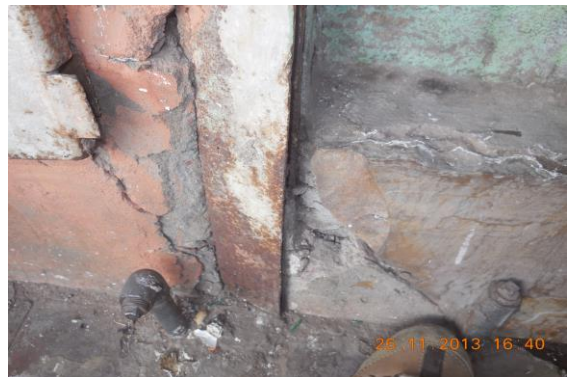
Photo 55

Damaged Portion on Outer Wall No. 3 of Varanda of Shop No.342B of Ground Floor

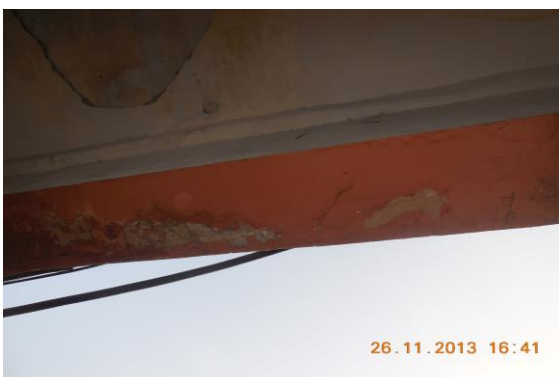
Photo 56

Dampness/Seepage on External Beam of Varanda of Shop No.341 of Ground Floor

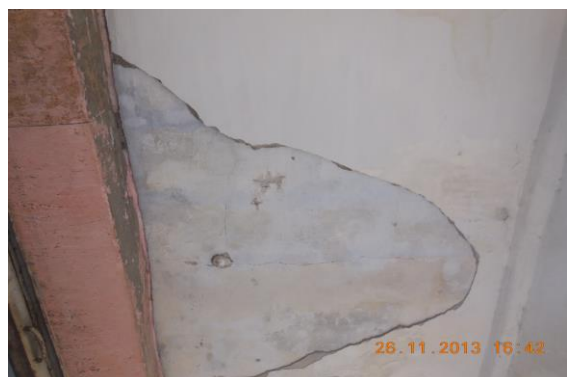
Photo 57

Peeling of Plaster on Roof of Varanda of Shop No.341 of Ground Floor

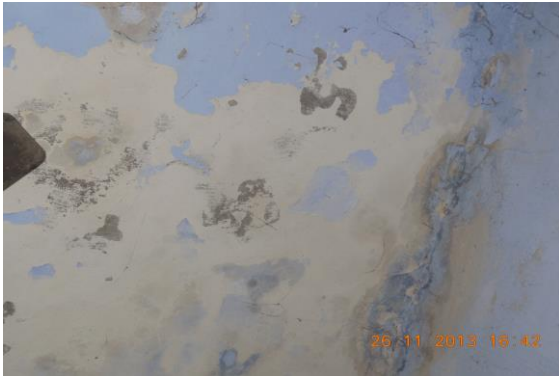
Photo 58

Dampness/Seepage on Wall No. 2 of Shop No.341 of Ground Floor

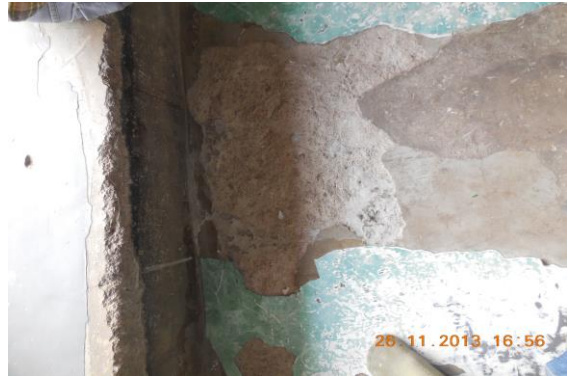
Photo 59

Peeling of Plaster on Floor of Varanda of Shop No.341 of Ground Floor

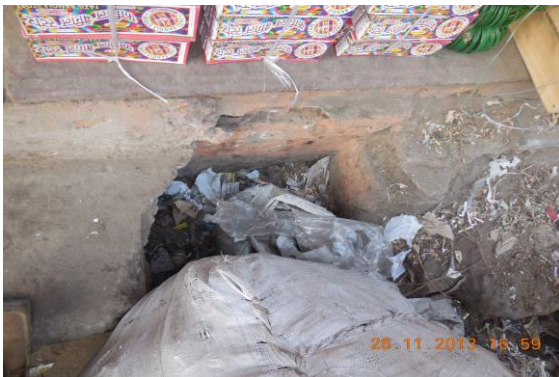
Photo 60

Damaged Portion on Staircase of Varanda of Ground Floor

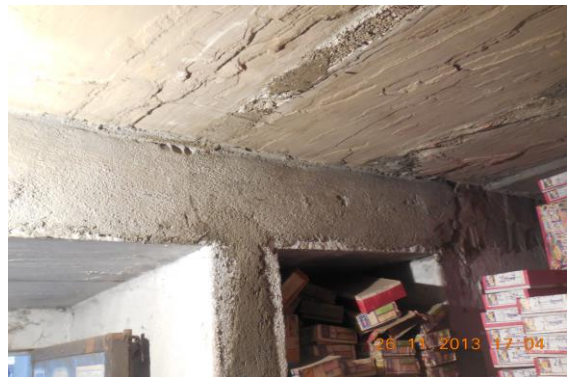
Photo 61

Peeling of Plaster on Wall No. 3 of Part B of Shop No.340 of Ground Floor

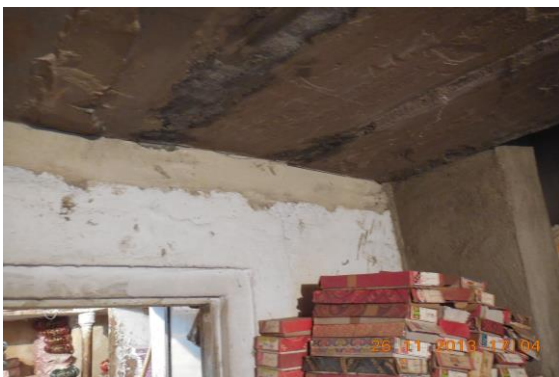
Photo 62

Peeling of Plaster on Wall No. 4 of Part B of Shop No.340 of Ground Floor

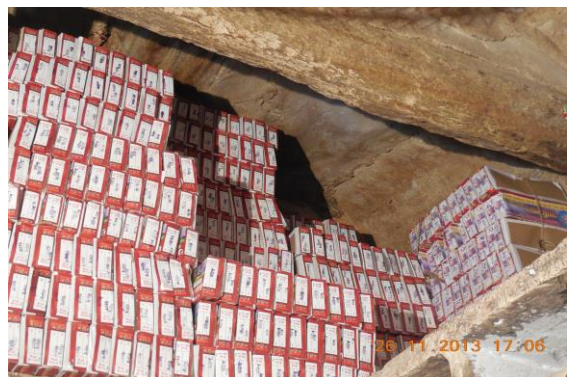
Photo 63

Dampness/Seepage on Wall No. 4 & Roof of Part C of Shop No.340 of Ground Floor

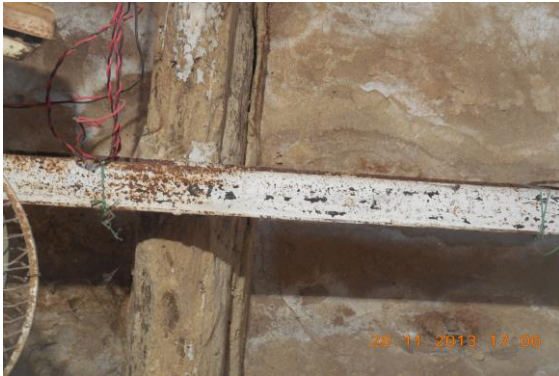
Photo 64

Dampness/Seepage on Wall No. 4 & Roof of Part C of Shop No.340 of Ground Floor

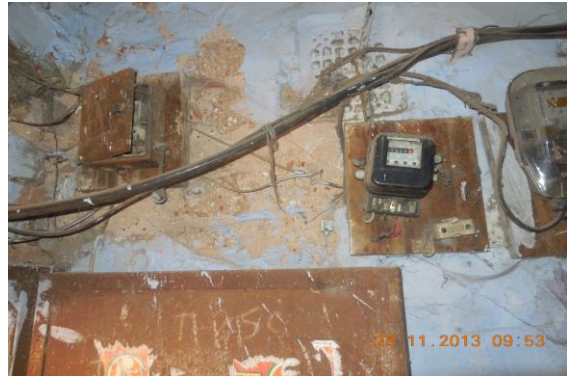
Photo 65

Peeling of Plaster on Wall No. 1 of Passage 1 of House No. 1902, Ground Floor

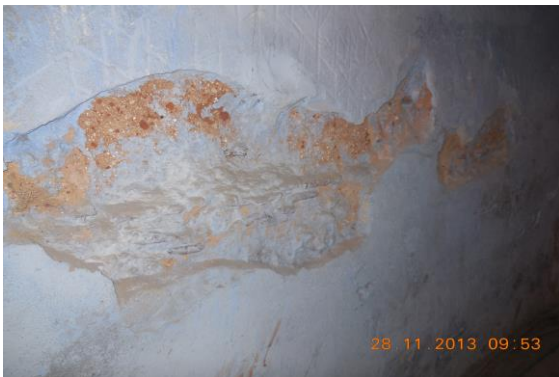
Photo 66

Peeling of Plaster on Wall No. 1 of Passage 1 of House No. 1902, Ground Floor

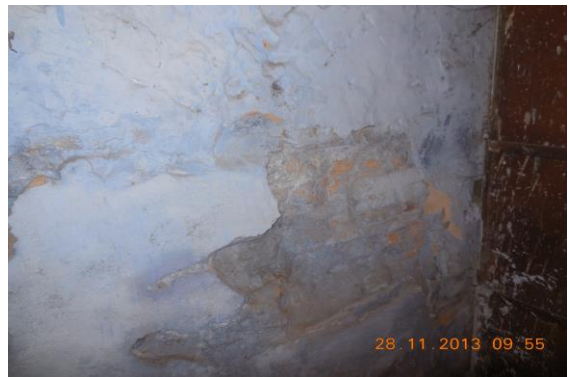
Photo 67

Peeling of Plaster on Wall No. 2 of Passage 1 of House No. 1902, Ground Floor

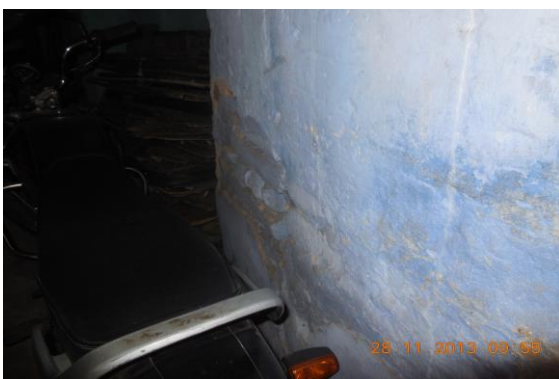
Photo 68

Peeling of Plaster on Wall No. 2 of Passage 1 of House No. 1902, Ground Floor

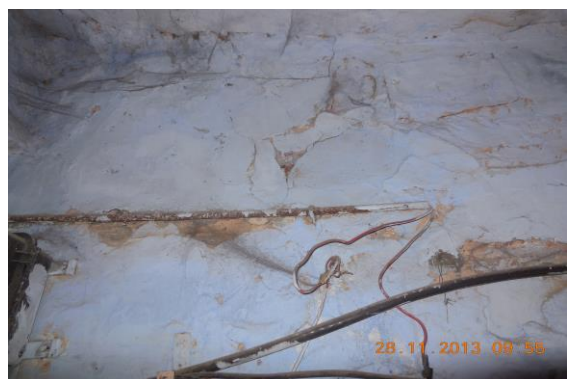
Photo 69

Peeling of Plaster on Wall No. 2 of Passage 1 of House No. 1902, Ground Floor

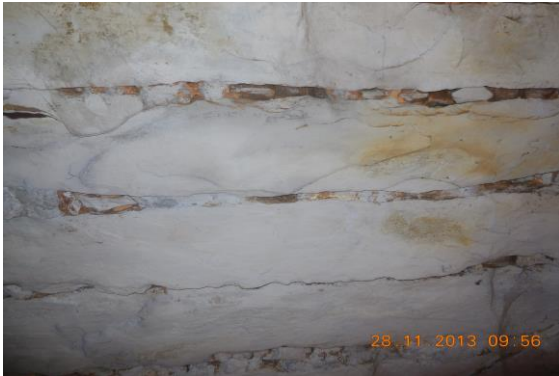
Photo 70

Dampness/Seepage on Roof of Passage 1 of House No. 1902, Ground Floor

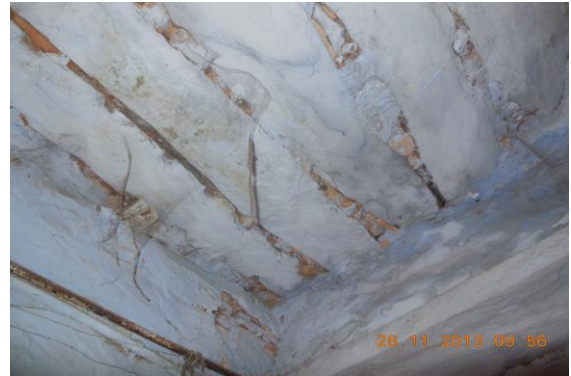
Photo 71

Dampness/Seepage on Roof of Passage 1 of House No. 1902, Ground Floor

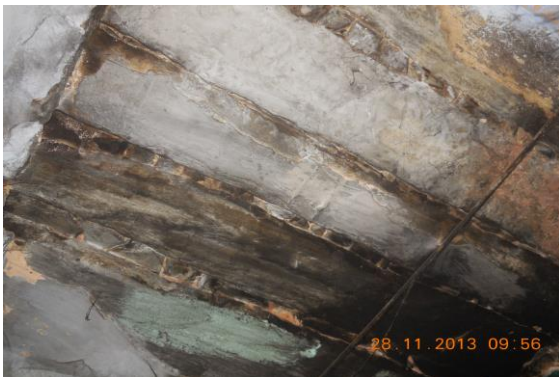
Photo 72

Dampness/Seepage on Roof of Passage 1 of House No. 1902, Ground Floor

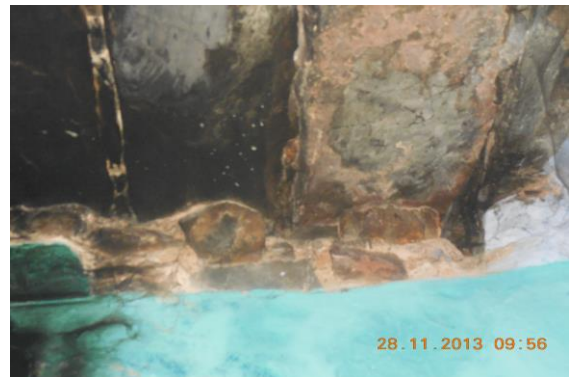
Photo 73

Dampness/Seepage on Roof of Passage 1 of House No. 1902, Ground Floor

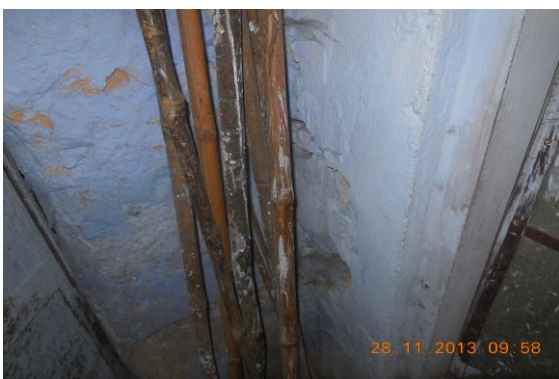
Photo 74

Peeling of Plaster on External wall No. 3 of Store 1 of House No. 1902, Ground Floor

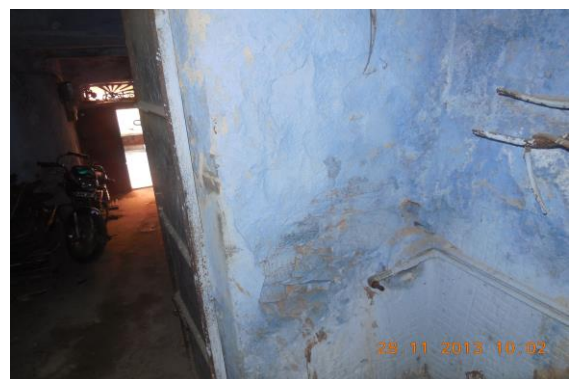
Photo 75

Peeling of Plaster on Wall No. 3 of Varanda of House No. 1902, Ground Floor

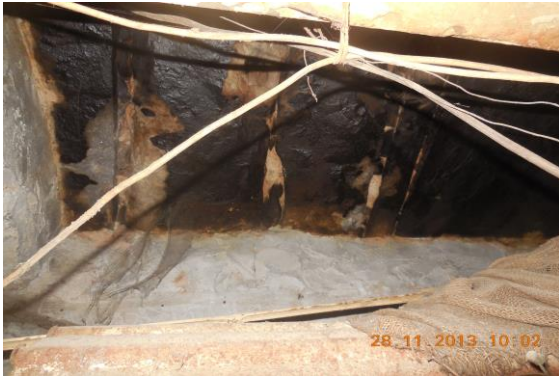
Photo 76

Peeling of Plaster on Roof of Varanda of House No. 1902, Ground Floor

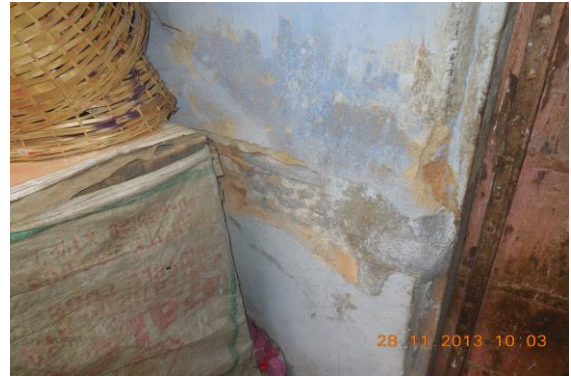
Photo 77

Peeling of Plaster on Wall No. 4 of Varandah of House No. 1902, Ground Floor

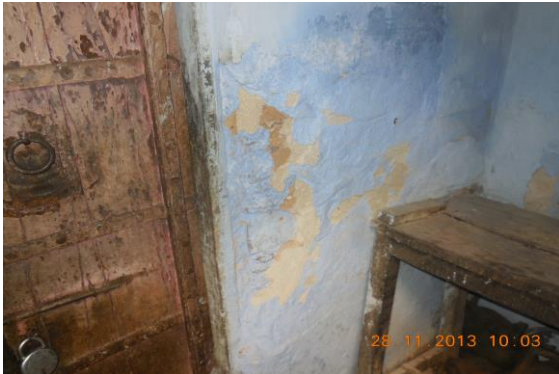
Photo 78

Peeling of Plaster on Wall No. 4 of Varandah of House No. 1902, Ground Floor

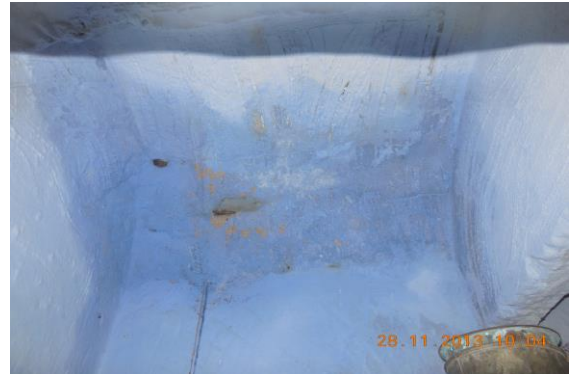
Photo 79

Dampness/Seepage on Roof of Varanda of House No. 1902, Ground Floor

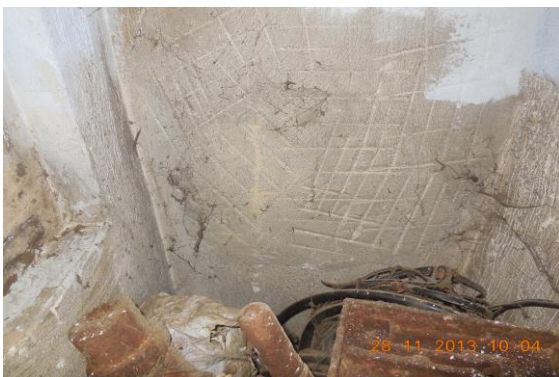
Photo 80

Dampness/Seepage on Roof of Varanda of House No. 1902, Ground Floor

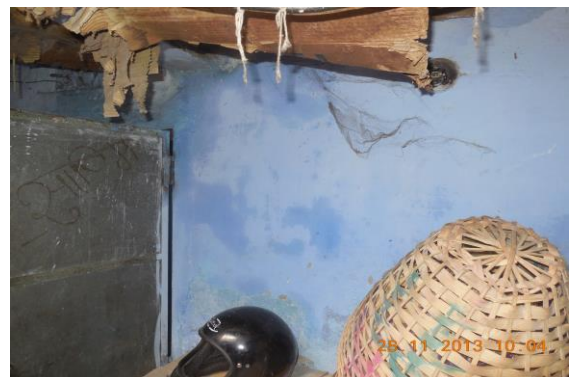
Photo 81

Dampness/Seepage on Wall No. 4 of Varanda of House No. 1902, Ground Floor

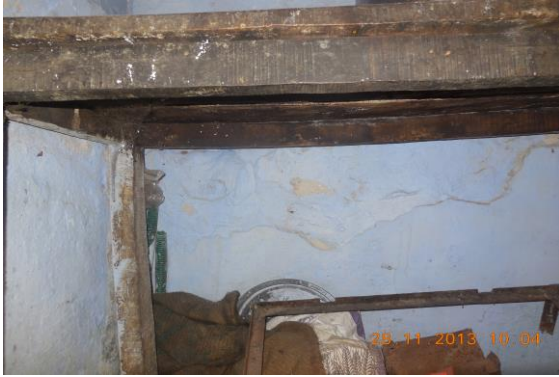
Photo 82

Peeling of Plaster on Wall No. 1 of Varanda of House No. 1902, Ground Floor

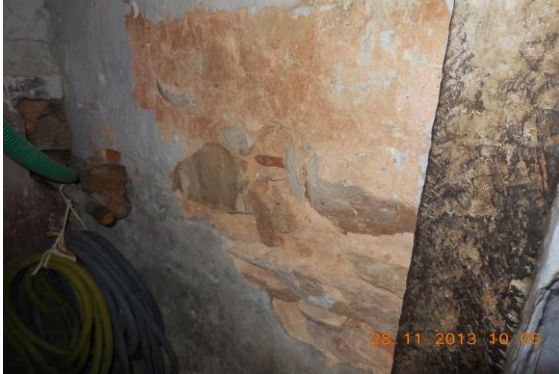
Photo 83

Peeling of Plaster on Wall No. 4 of Bathroom No. of House No. 1902, Ground Floor

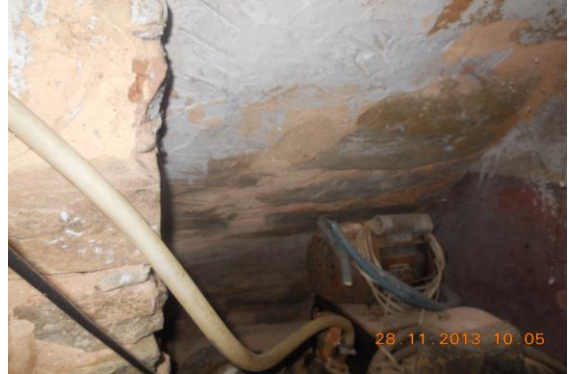
Photo 84

Peeling of Plaster on Wall No. 2 of Bathroom No. of House No. 1902, Ground Floor

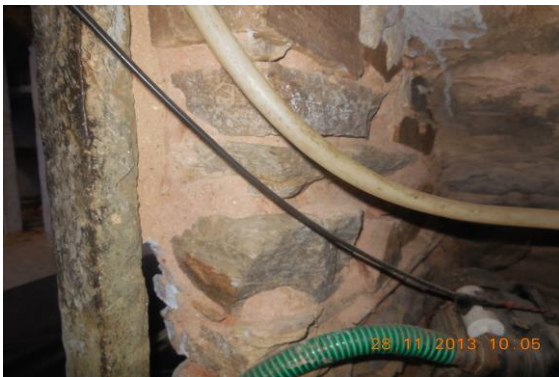
Photo 85

Peeling of Plaster on Wall No. 1 of Bathroom of House No. 1902, Ground Floor

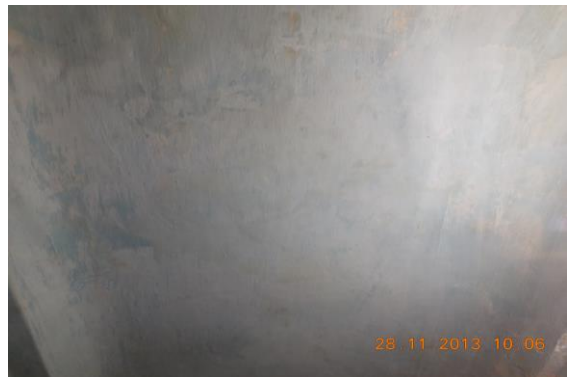
Photo 86

Peeling of Plaster on Wall No. 3 of Bathroom of House No. 1902, Ground Floor

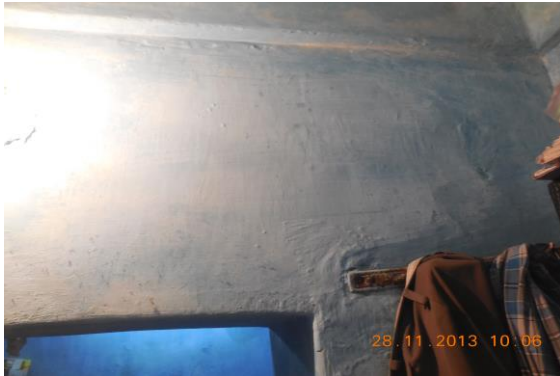
Photo 87

Dampness/Seepage on Roof of House No. 1902 of Ground Floor

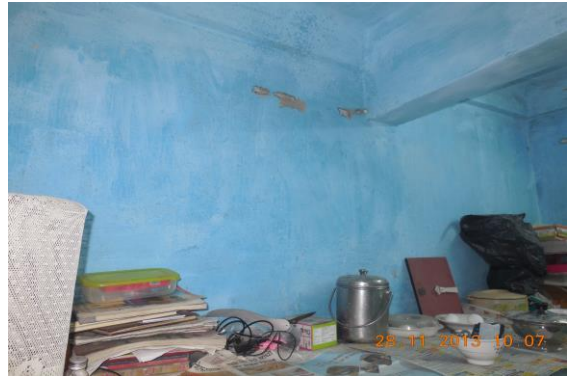
Photo 88

Dampness/Seepage on Wall No. 4 of Lobby of House No. 1902, Ground Floor

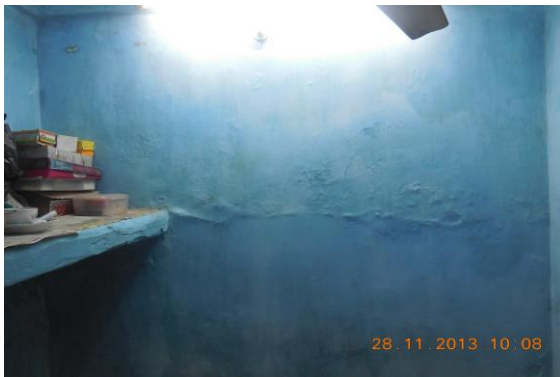
Photo 89

Dampness/Seepage on Wall No. 1 of Room No. 1 of House No. 1902, Ground Floor

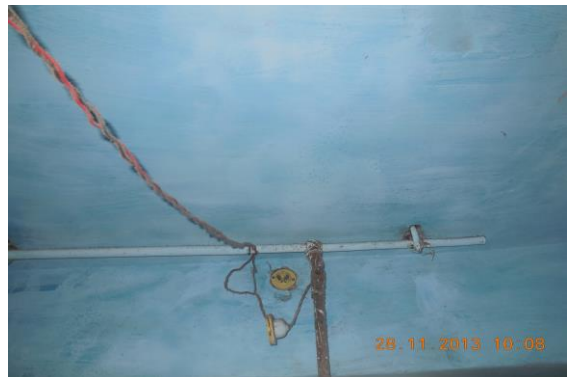
Photo 90

Dampness/Seepage on Wall No. 4 of Room No. 1 of House No. 1902, Ground Floor

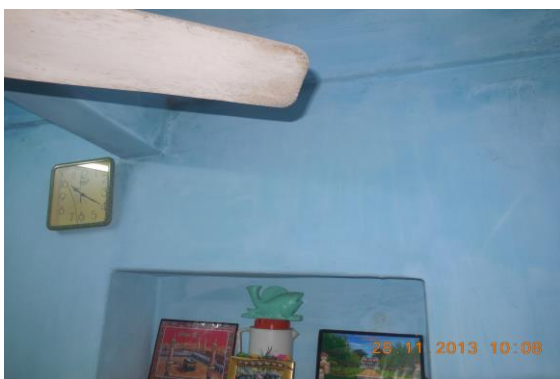
Photo 91

Dampness/Seepage on Roof of Room No. 1 of House No. 1902, Ground Floor

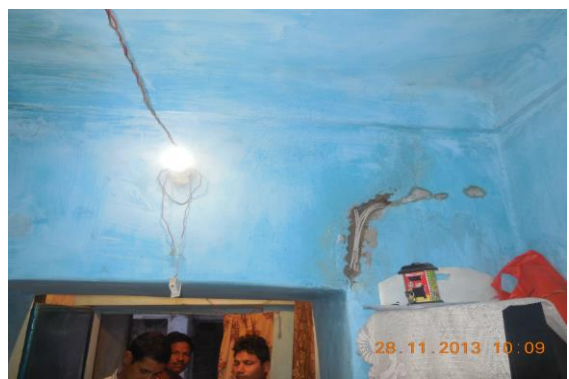
Photo 92

Dampness/Seepage on Wall No. 2 of Room No. 1 of House No. 1902, Ground Floor

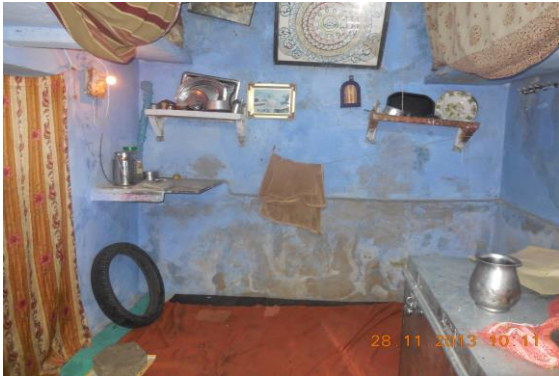
Photo 93

Dampness/Seepage on Wall No. 2 of Room No. 1 of House No. 1902, Ground Floor

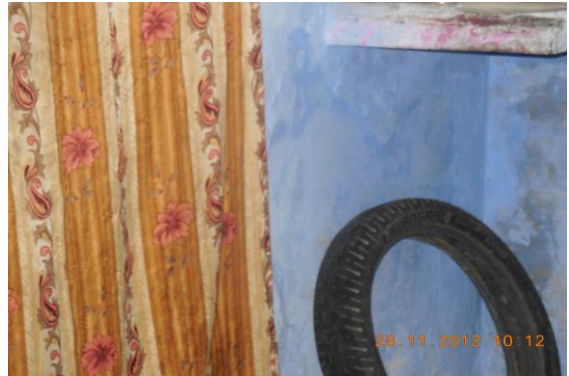
Photo 94

Dampness/Seepage on Wall No. 4 of Room No. 2 of House No. 1902, Ground Floor

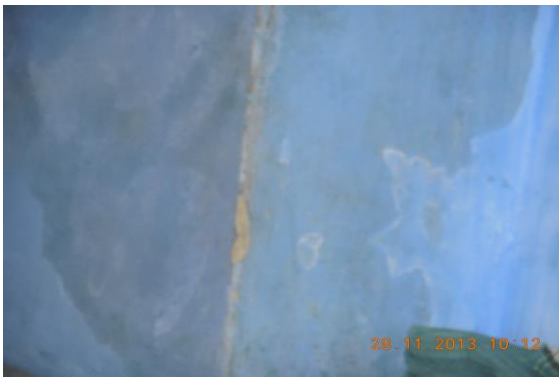
Photo 95

Dampness/Seepage on Wall No. 1 of Room No. 2 of House No. 1902, Ground Floor

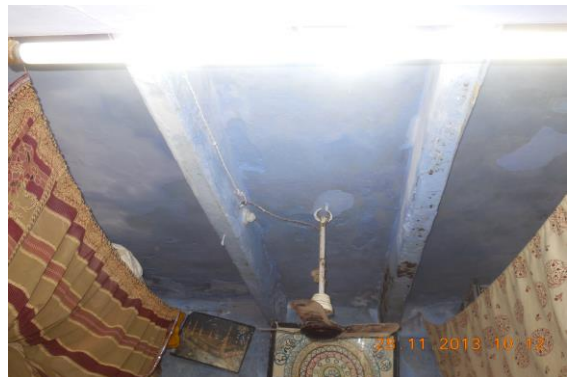
Photo 96

Dampness/Seepage on Wall No. 2 of Room No. 2 of House No. 1902, Ground Floor

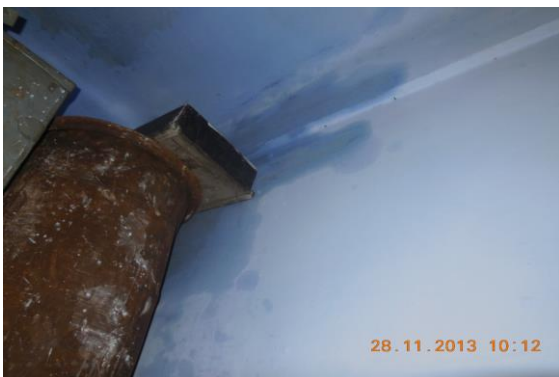
Photo 97

Dampness/Seepage on Roof of Room No. 2 of House No. 1902, Ground Floor

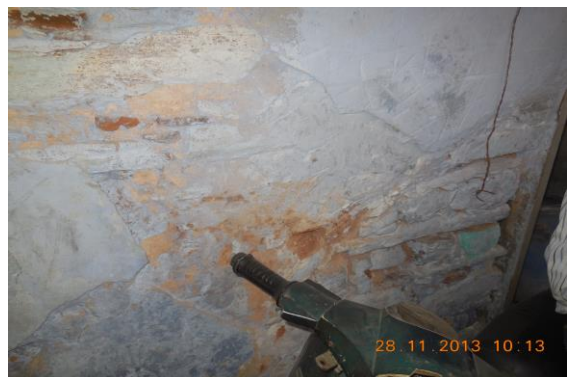
Photo 98

Dampness/Seepage on Wall No. 3 of Room No. 2 of House No. 1902, Ground Floor

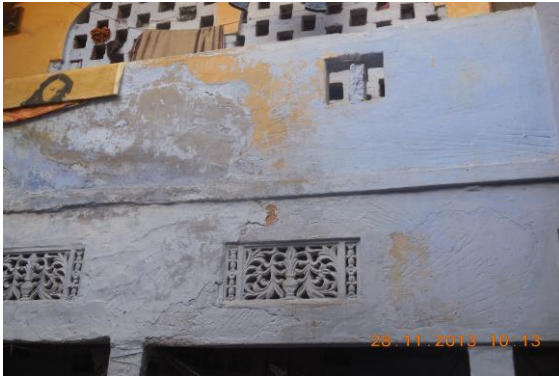
Photo 99

Peeling of Plaster on Wall No. 3 of Open Area of House No. 1902, Ground Floor

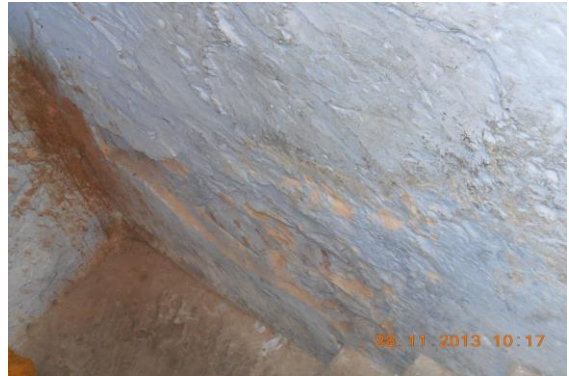
Photo 100

Dampness/Seepage on Wall No. 4 of Open Area of House No. 1902, Ground Floor

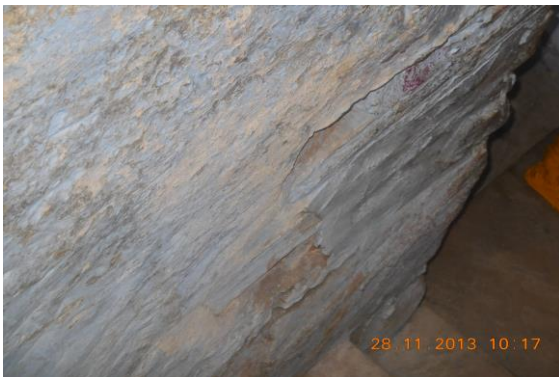
Photo 101

Peeling of Plaster on Wall No. 1 of Stair 1 of House No. 1902, First Floor

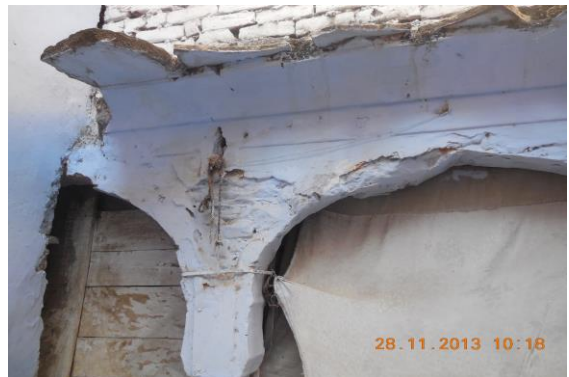
Photo 102

Peeling of Plaster on Wall No. 2 of Stair 1 of House No. 1902, First Floor

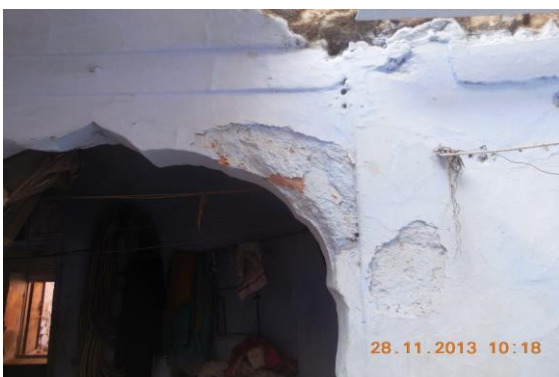
Photo 103

Peeling of Plaster on Wall No. 1 of Open Area of House No. 1902, First Floor

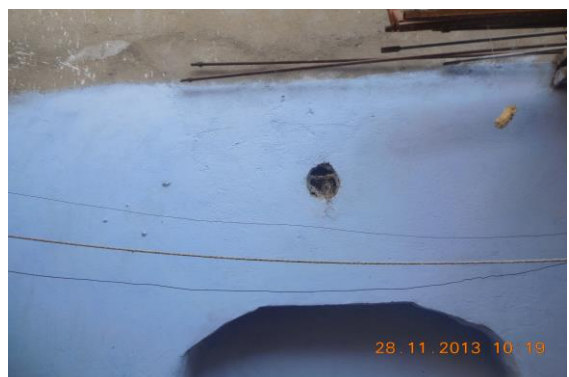
Photo 104

Peeling of Plaster on Wall No. 1 of Open Area of House No. 1902, First Floor

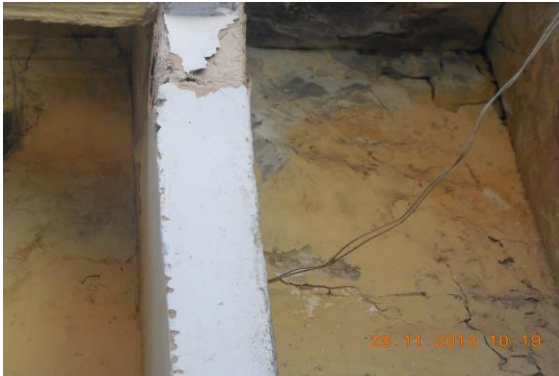
Photo 105

Peeling of Plaster on Wall No. 4 of Open Area of House No. 1902, First Floor

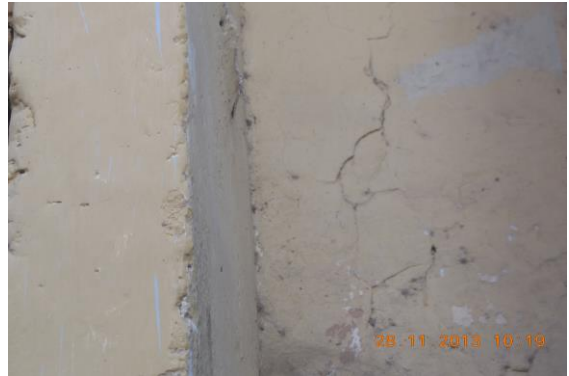
Photo 106

Peeling of Plaster on Wall No. 3 of Open Area of House No. 1902, First Floor

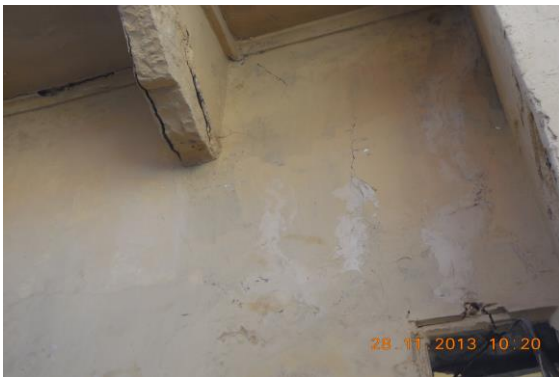
Photo 107

Peeling of Plaster on Wall No. 3 of Open Area of House No. 1902, First Floor

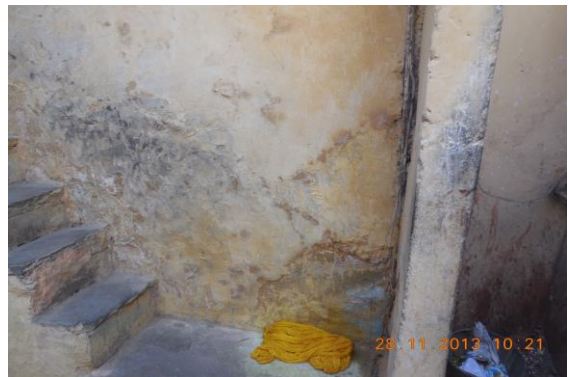
Photo 108

Peeling of Plaster on Wall No. 3 of Open Area of House No. 1902, First Floor

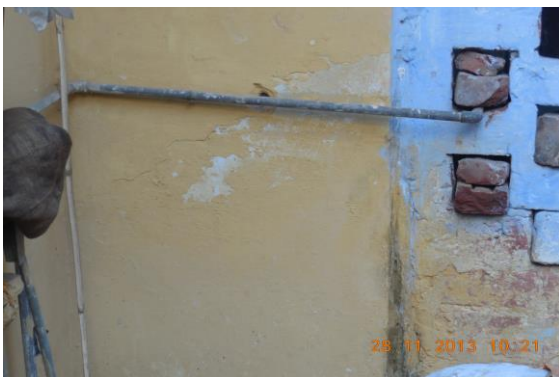
Photo 109

Dampness/Seepage on Wall No. 3 of Open Area of House No. 1902, First Floor

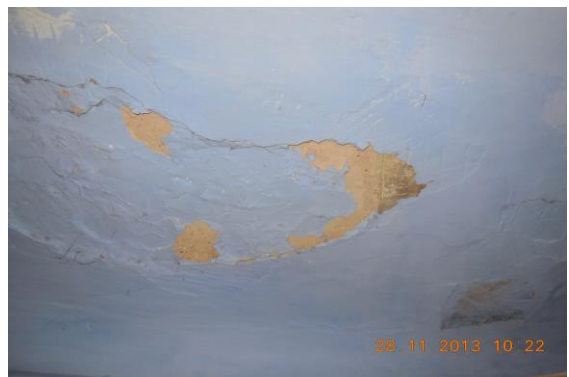
Photo 110

Dampness/Seepage on Wall No. 2 of Open Area of House No. 1902, First Floor

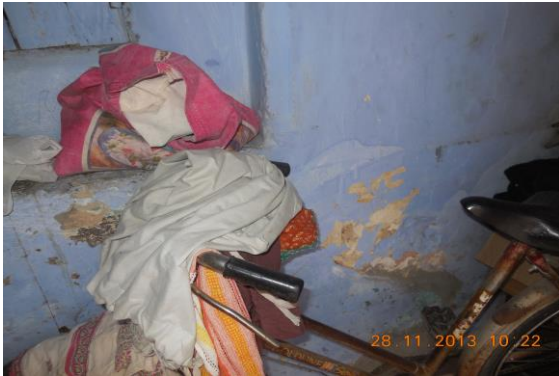
Photo 111

Peeling of Plaster on Roof of Varanda 1 of House No. 1902, First Floor

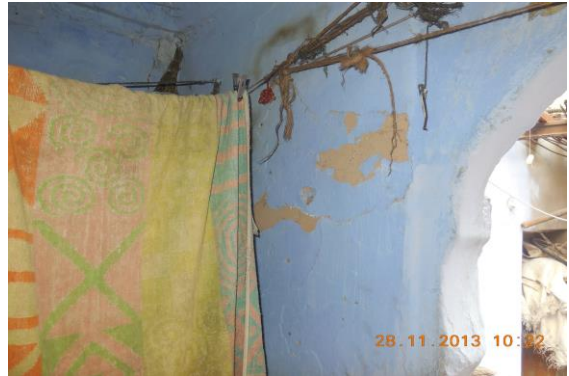
Photo 112

Dampness/Seepage on Wall No. 4 of Varanda 1 of House No. 1902, First Floor

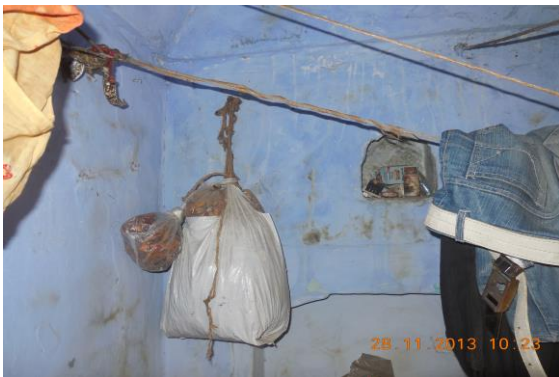
Photo 113

Dampness/Seepage on Wall No. 3 of Varanda 1 of House No. 1902, First Floor

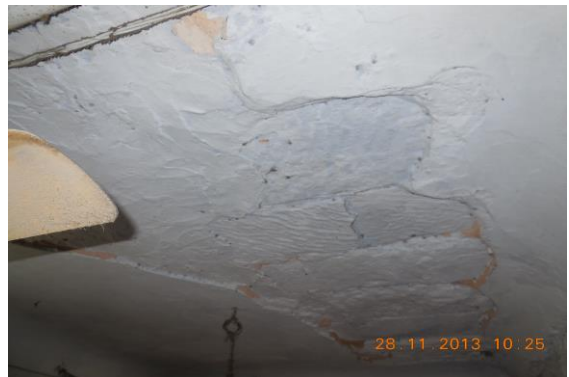
Photo 114

Dampness/Seepage on Wall No. 2 of Varanda 1 of House No. 1902, First Floor

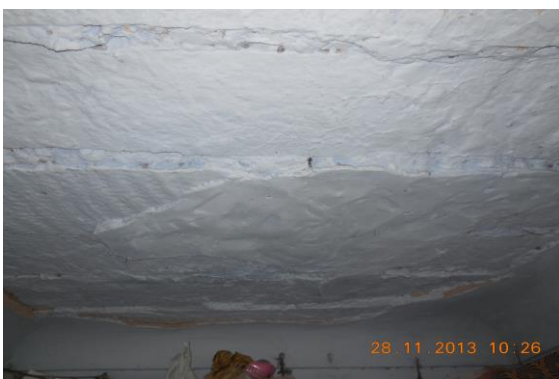
Photo 115

Peeling of Plaster on Roof of Varanda 2 of House No. 1902, First Floor

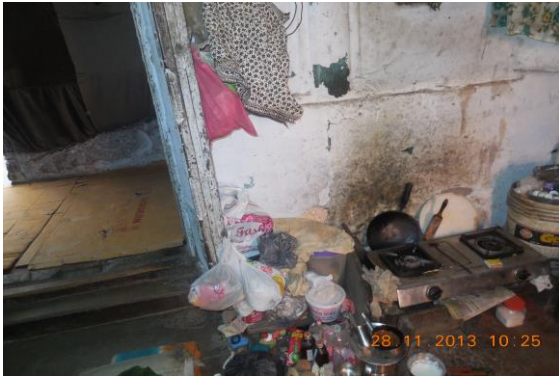
Photo 117

Peeling of Plaster on Wall No. 1 of Varanda 2 of House No. 1902, First Floor

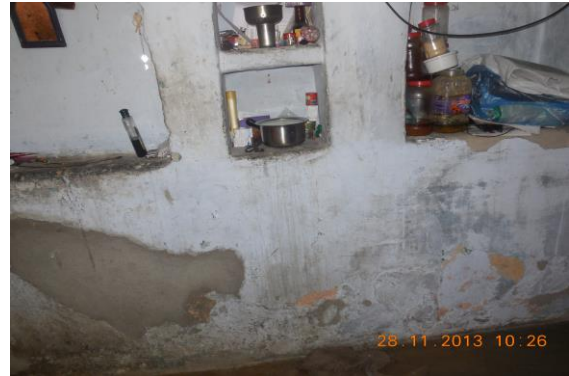
Photo 118

Peeling of Plaster on Wall No. 3 of Varanda 2 of House No. 1902, First Floor

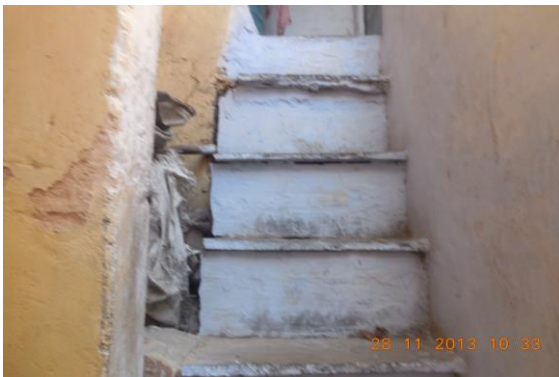
Photo 119

Peeling of Plaster on Wall No. 4 of Varanda 2 of House No. 1902, First Floor

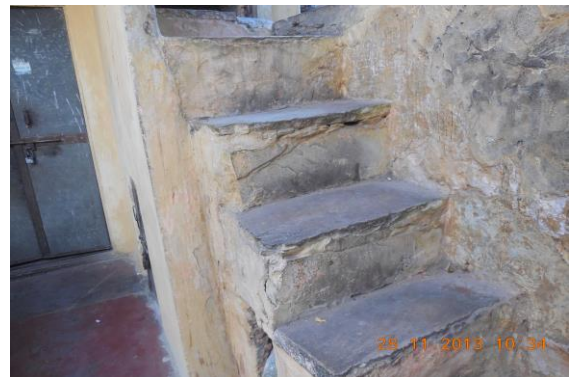
Photo 120

Peeling of Plaster on Stair 1 of House No. 1902, Second Floor

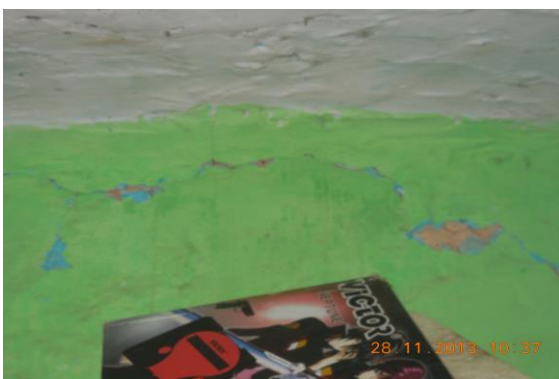
Photo 121

Peeling of Plaster on Stair 2 of House No. 1902, Second Floor

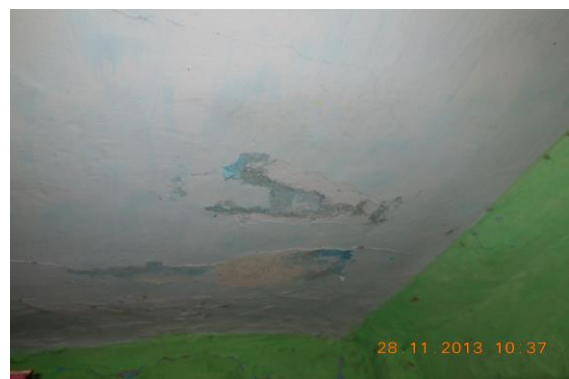
Photo 123

Dampness/Seepage on Roof of Varanda 1 of House No. 1902, Second Floor

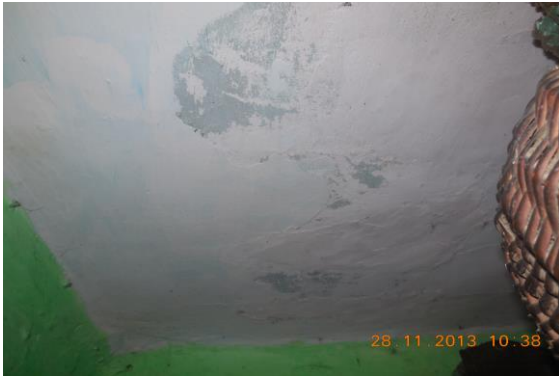
Photo 124

Dampness/Seepage on Roof of Varanda 1 of House No. 1902, Second Floor

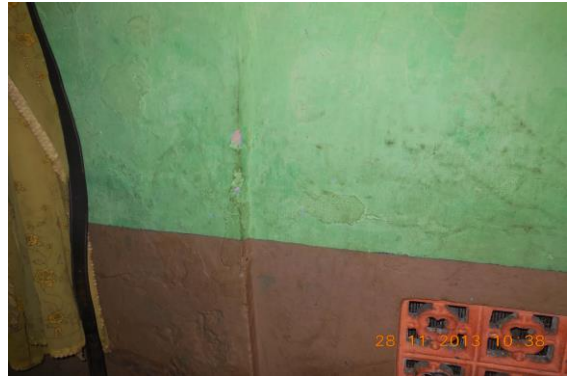
Photo 125

Dampness/Seepage on Wall No. 4 of Varanda 1 of House No. 1902, Second Floor

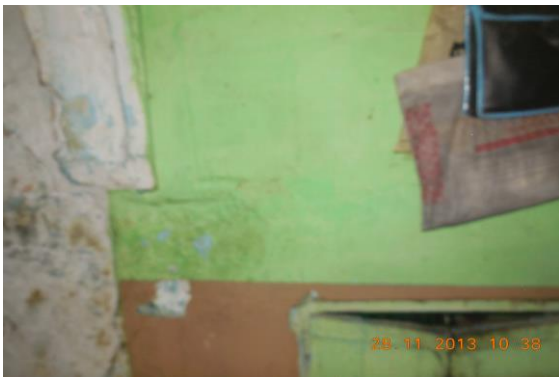
Photo 126

Dampness/Seepage on Wall No. 2 of Varanda 1 of House No. 1902, Second Floor

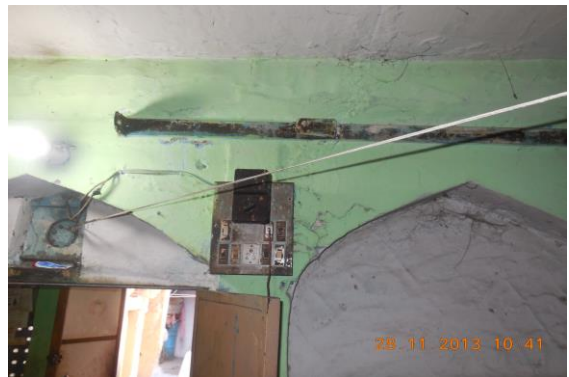
Photo 127

Peeling of Plaster on Wall No. 3 of Room No. 1 of House No. 1902, Second Floor

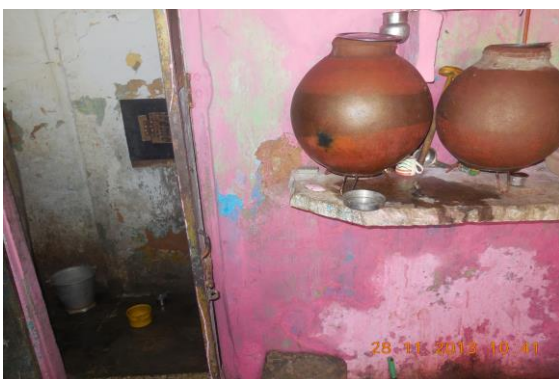
Photo 128

Dampness/Seepage on Wall No. 4 of Room No. 1 of House No. 1902, Second Floor

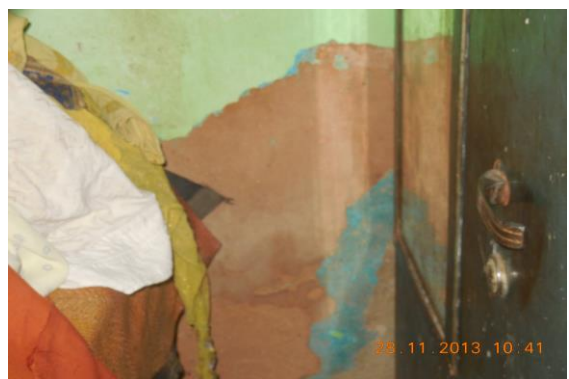
Photo 129

Dampness/Seepage on Wall No. 1 of Room No. 1 of House No. 1902, Second Floor

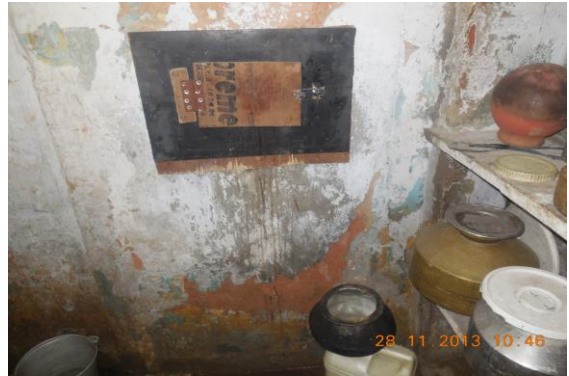
Photo 131

Dampness/Seepage on Wall No. 2 of Bathroom of House No. 1902, Second Floor
