### Pre Building Condition Survey Report

Name and Address of Structure :	Badi Chopar to Ramp Area (UP Line)
---------------------------------	------------------------------------

Name of the Project	<b>Contract JMRC-UG1B</b> “Design and Construction of Tunnel between Chandpole and Badi Chouper and reverse line by Shield TBM, Underground Metro Stations at Choti Chouper and Badi Chouper by Cut and Cover Methods on East West Corridor of Jaipur Metro Rail Corporation Limited .”	
Owner :

Pre Building Condition Survey Report Badi Chopar to Ramp Area (UP Line)

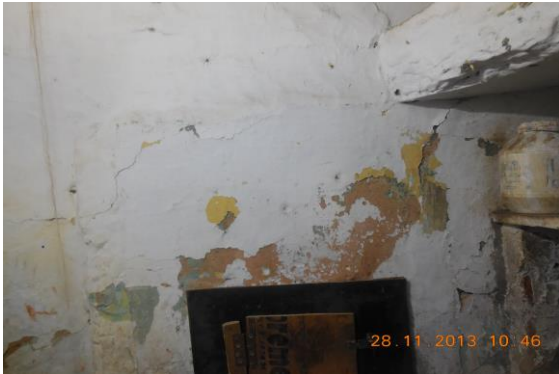
Photo 132

Dampness/Seepage on Wall No. 2 of Bathroom of House No. 1902, Second Floor

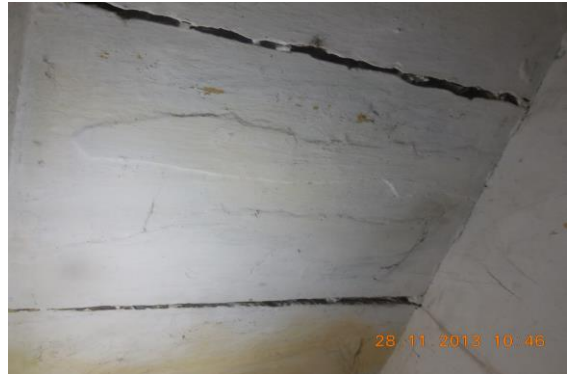
Photo 133

Dampness/Seepage on Roof of Bathroom of House No. 1902, Second Floor

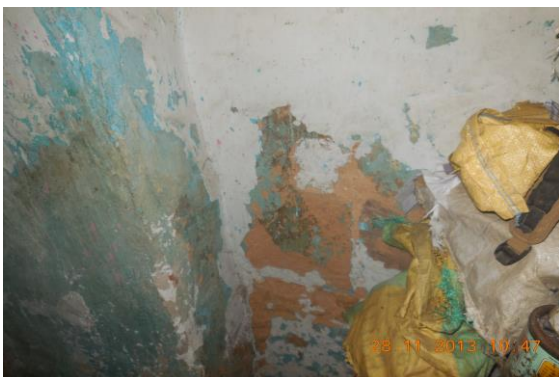
Photo 134

Dampness/Seepage on Wall No. 2 of Toilet No. 1 of House No. 1902, Second Floor

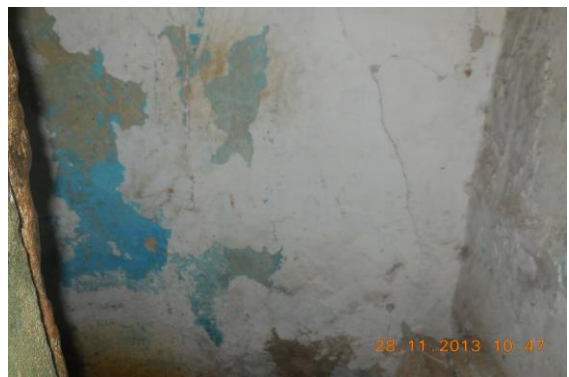
Photo 135

Dampness/Seepage on Wall No. 4 of Toilet No. 1 of House No. 1902, Second Floor

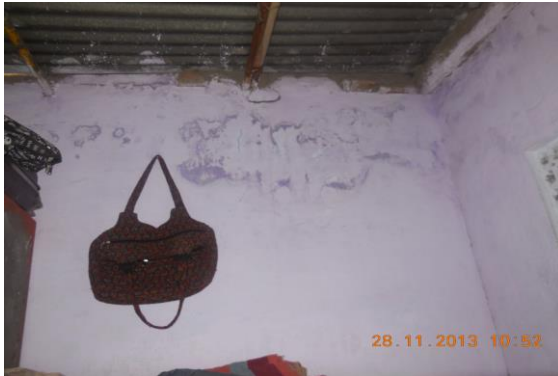
Photo 136

Dampness/Seepage on Wall No. 4 of Room No. 1 of House No. 1902, Second Floor

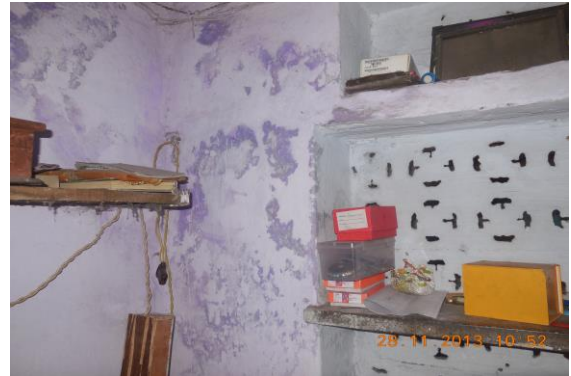
Photo 137

Dampness/Seepage on Wall No. 1 of Room No. 1 of House No. 1902, Second Floor

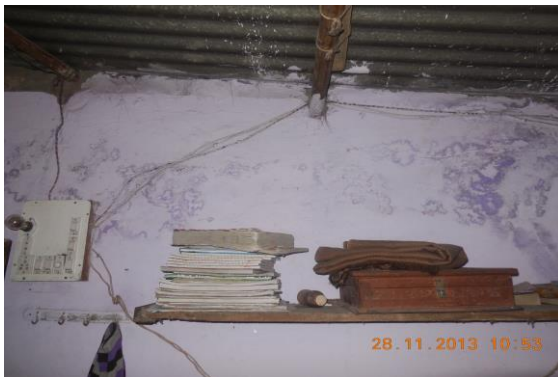
Photo 138

Dampness/Seepage on Wall No. 3 of Room No. 1 of House No. 1902, Second Floor

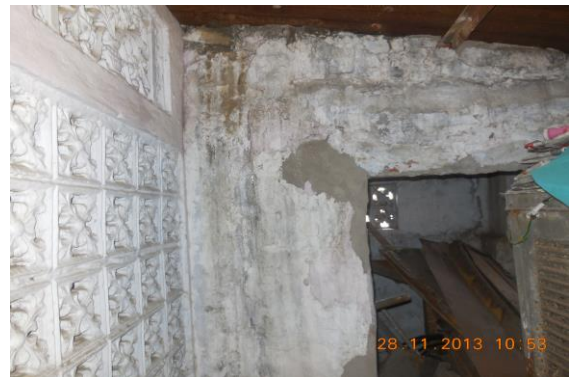
Photo 139

Dampness/Seepage on Wall No. 1 of Varanda 1 of House No. 1902, Third Floor

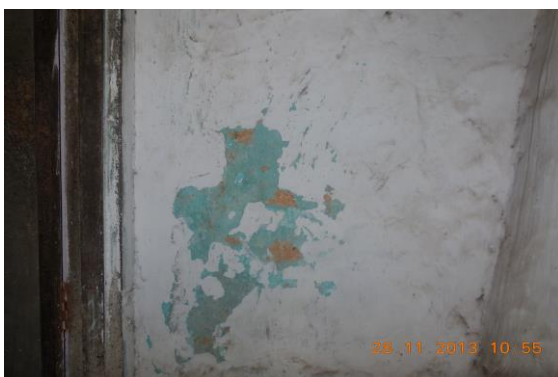
Photo 140

Dampness/Seepage on Wall No. 4 of Stair 1 of House No. 1902, Third Floor

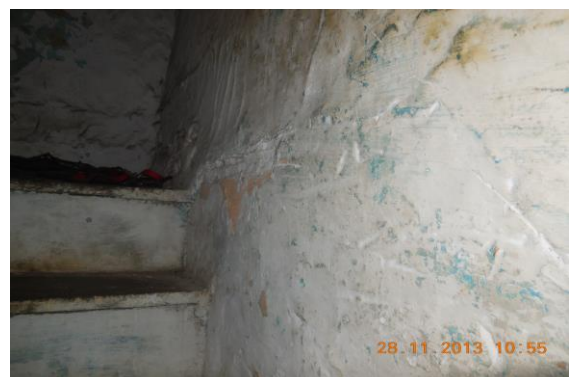
Photo 141

Dampness/Seepage on Wall No. 2 of Stair 1 of House No. 1902, Third Floor

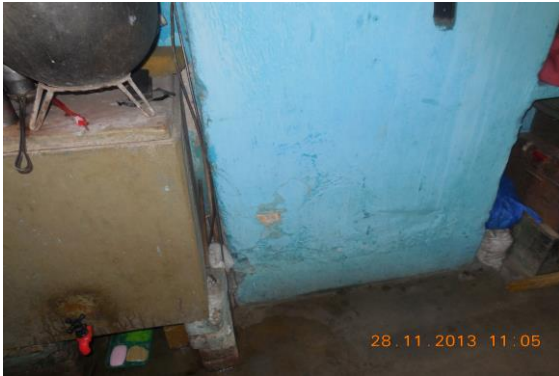
Photo 142

Dampness/Seepage on Wall No. 1 of Room No. 3 of House No. 1902, Upper First Floor

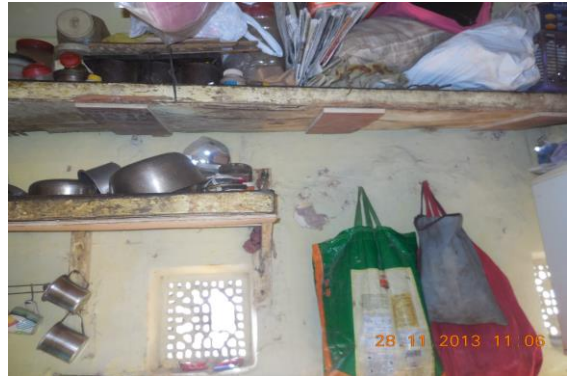
Photo 143

Peeling of Plaster on Wall No. 4 of Store 1 of House No. 1902, Upper First Floor

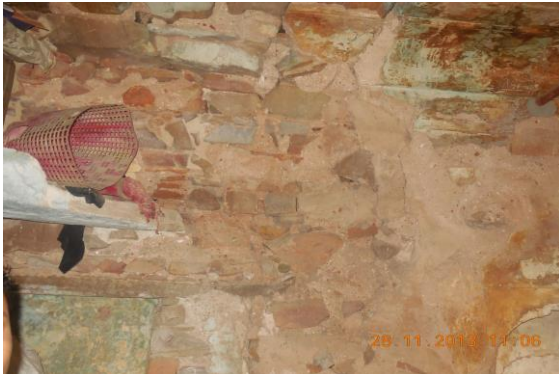
Photo 144

Peeling of Plaster on Wall No. 4 of Room No. 1 of House No. 1902, Upper First Floor

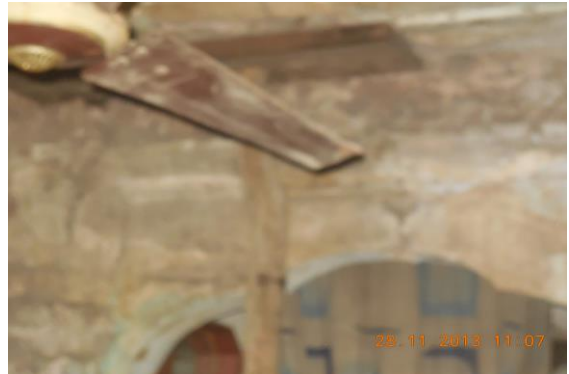
Photo 145

Peeling of Plaster on Wall No. 2 of Room No. 1 of House No. 1902, Upper First Floor

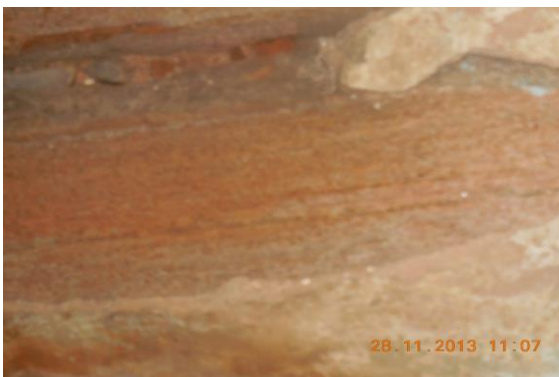
Photo 146

Peeling of Plaster on Roof of Room No. 1 of House No. 1902, Upper First Floor

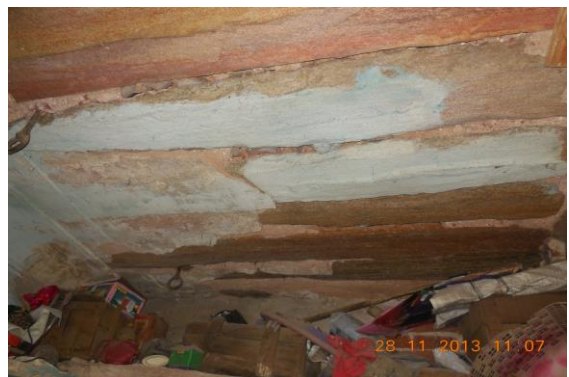
Photo 147

Peeling of Plaster on Roof of Room No. 1 of House No. 1902, Upper First Floor

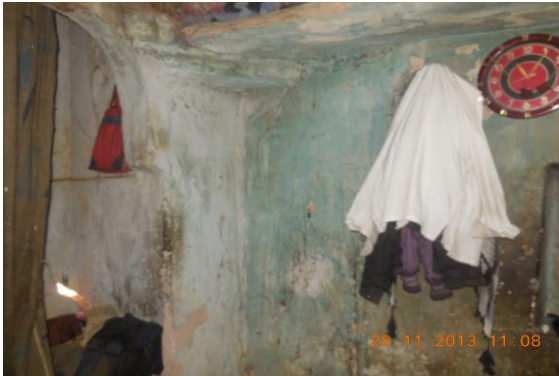
Photo 148

Peeling of Plaster on Wall No. 3 of Room No. 1 of House No. 1902, Upper First Floor

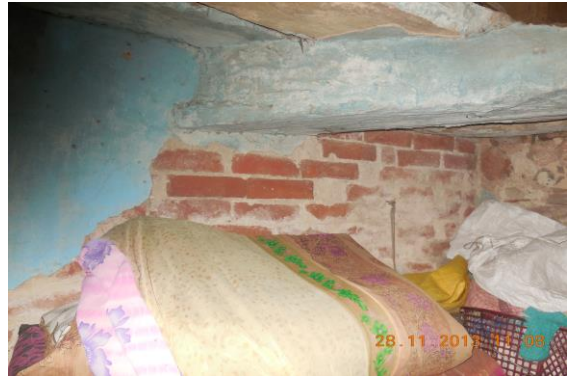
Photo 149

Peeling of Plaster on Wall No. 1 of Room No. 1 of House No. 1902, Upper First Floor

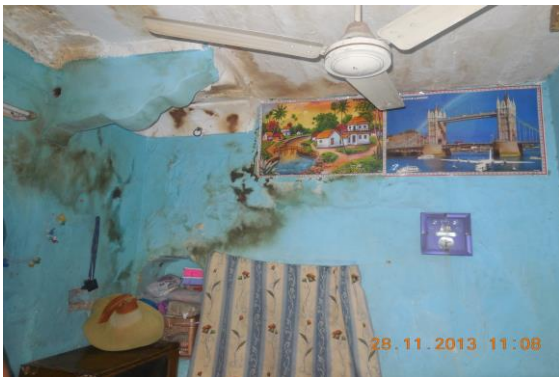
Photo 150

Dampness/Seepage on Wall No. 4 of Room No. 2 of House No. 1902, Upper First Floor

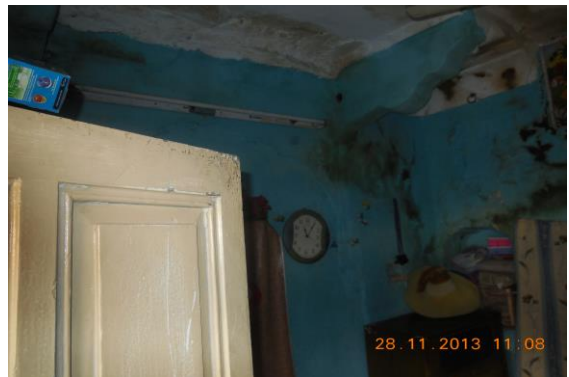
Photo 151

Dampness/Seepage on Wall No. 1 of Room No. 2 of House No. 1902, Upper First Floor

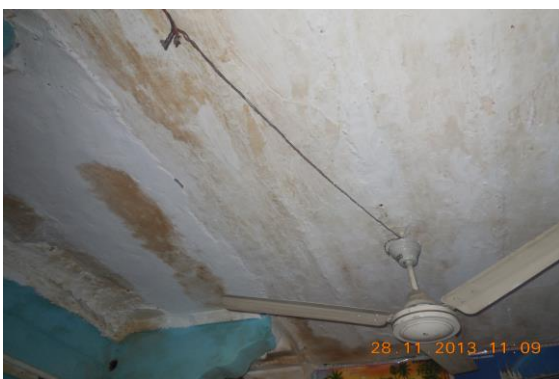
Photo 152

Dampness/Seepage on Roof of Room No. 2 of House No. 1902, Upper First Floor

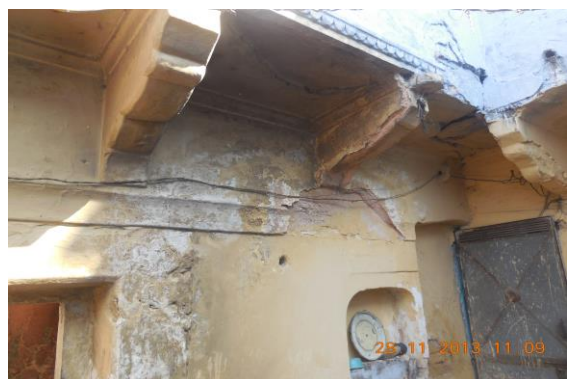
Photo 153

Peeling of Plaster on Wall No. 3 of Open Area 1 of House No. 1902, Upper First Floor

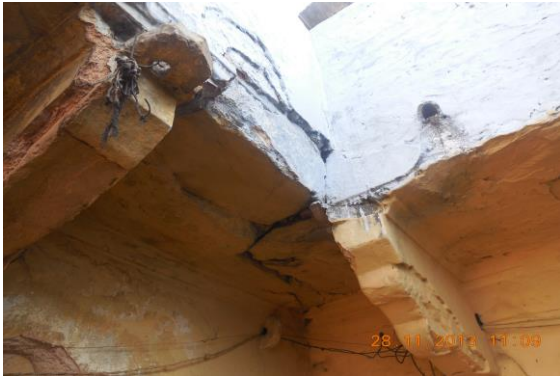
Photo 154

Peeling of Plaster on Roof & 3 of Open Area 1 of House No. 1902, Upper First Floor

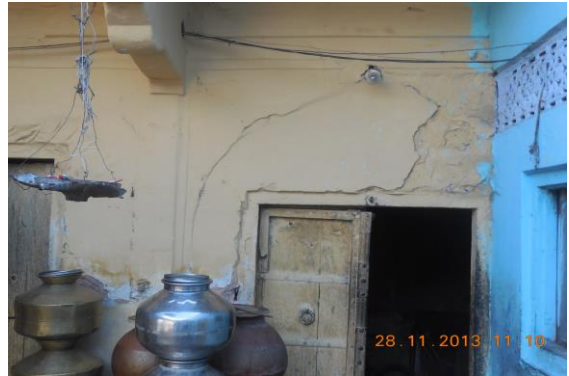
Photo 155

Peeling of Plaster on Wall No. 1 of Open Area 1 of House No. 1902, Upper First Floor

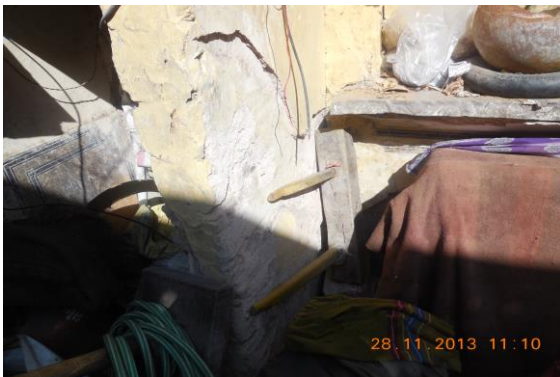
Photo 156

Peeling of Plaster on Wall No. 2 of Open Area 1 of House No. 1902, Upper First Floor

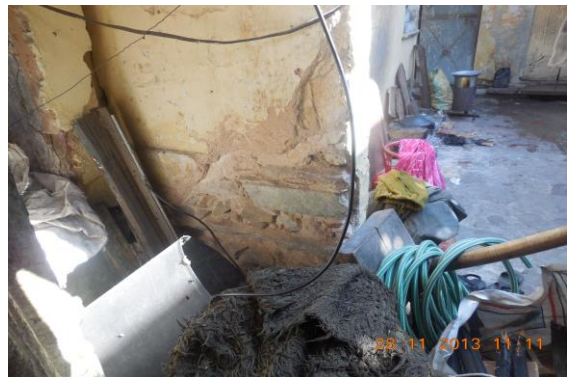
Photo 157

Peeling of Plaster on Wall No. 2 of Gallery of House No. 1902, Upper First Floor

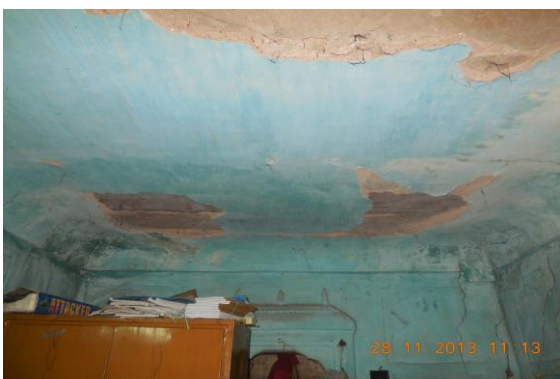
Photo 158

Peeling of Plaster on Roof of Room No. 4 of House No. 1902, Upper First Floor

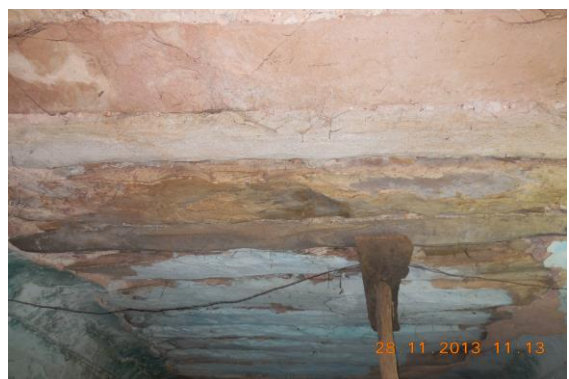
Photo 159

Peeling of Plaster on Roof of Room No. 4 of House No. 1902, Upper First Floor

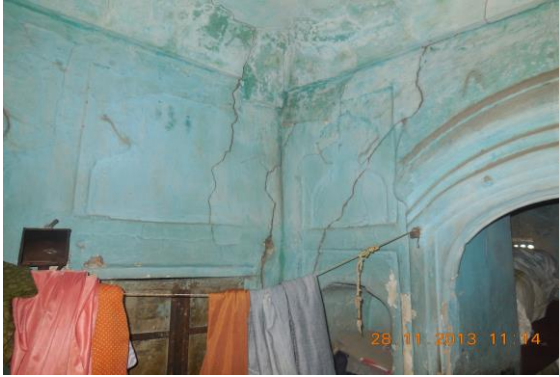
Photo 160

Peeling of Plaster on Wall No. 1 & 4 of Room No. 4 of House No. 1902, Upper First Floor

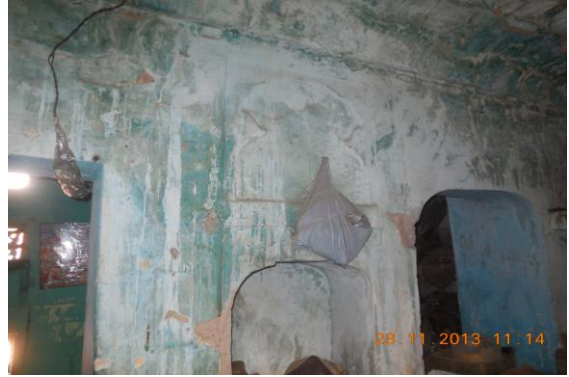
Photo 161

Dampness/Seepage on Wall No. 4 of Room No. 4 of House No. 1902, Upper First Floor

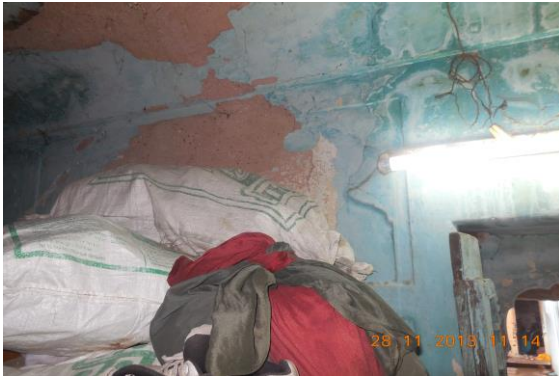
Photo 162

Peeling of Plaster on Wall No. 3 of Room No. 4 of House No. 1902, Upper First Floor

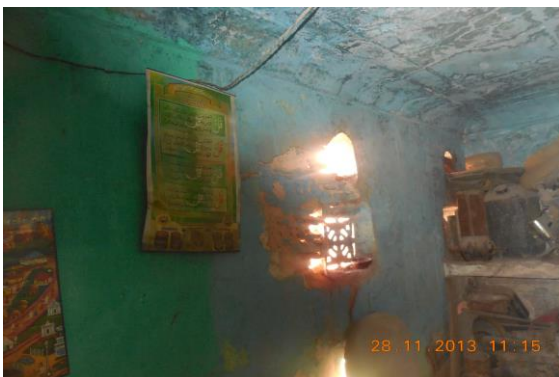
Photo 163

Peeling of Plaster on Wall No. 3 of Room No. 4 of House No. 1902, Upper First Floor

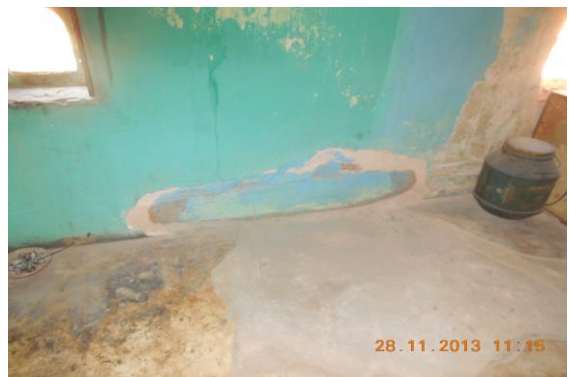
Photo 164

Peeling of Plaster on Wall No. 4 of Balcony of House No. 1902, Upper First Floor

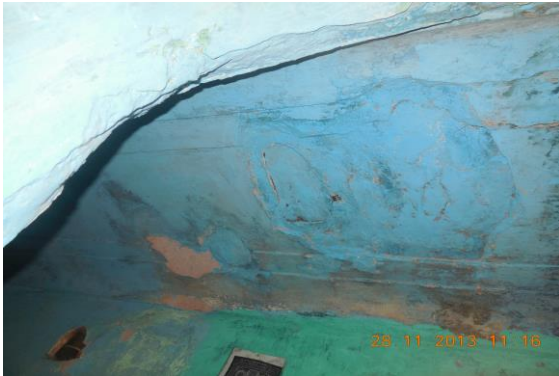
Photo 165

Peeling of Plaster on Wall No. 4 of Balcony of House No. 1902, Upper First Floor

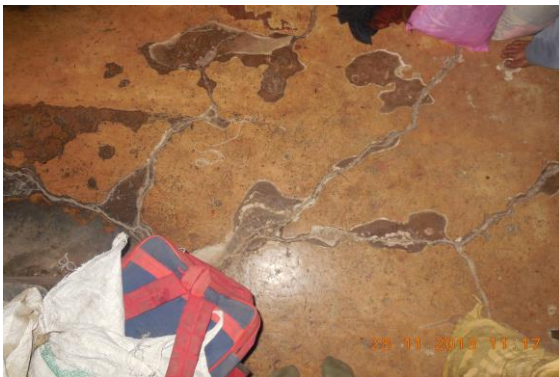
Photo 167

Peeling of Plaster on Wall No. Floor of Balcony of House No. 1902, Upper First Floor

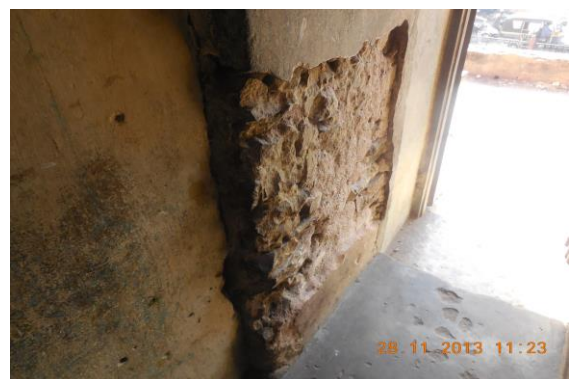
Photo 170

Dampness/Seepage on Roof of Varanda 1 of House No. 1902, Upper First Floor

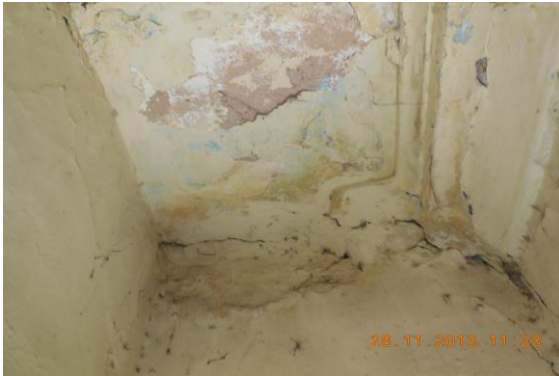
Photo 171

Peeling of Plaster on Wall No. 1 of Gallery of House No. 1902, Upper First Floor

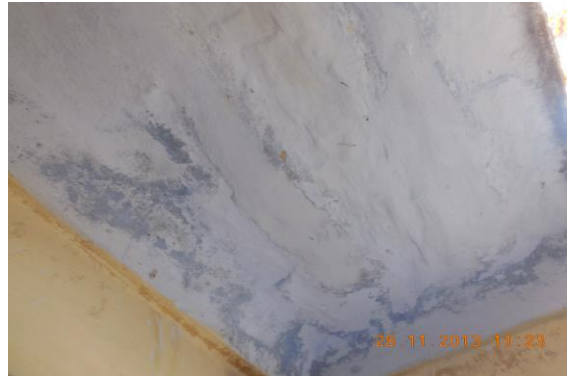
Photo 172

Peeling of Plaster on Roof of Gallery of House No. 1902, Upper First Floor

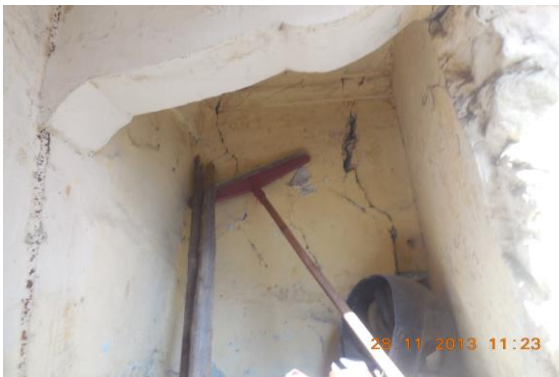
Photo 173

Dampness/Seepage on Roof of Gallery of House No. 1902, Upper First Floor

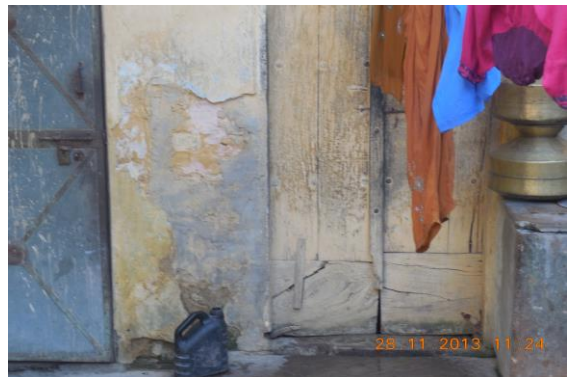
Photo 174

Peeling of Plaster on Wall No. 3 of Gallery of House No. 1902, Upper First Floor

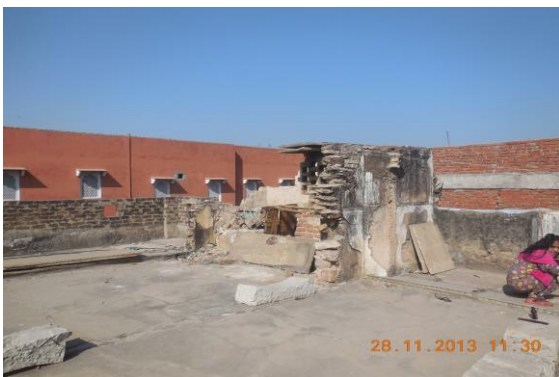
Photo 175

Peeling of Plaster on Wall No. 1 of Open Area of House No. 1902, Upper First Floor

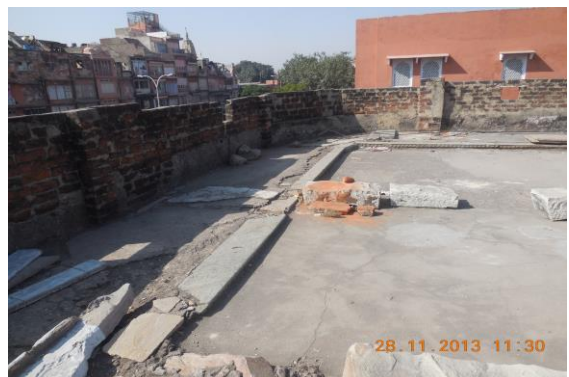
Photo 176

Peeling of Plaster on Terrace of House No. 1902, Upper First Floor

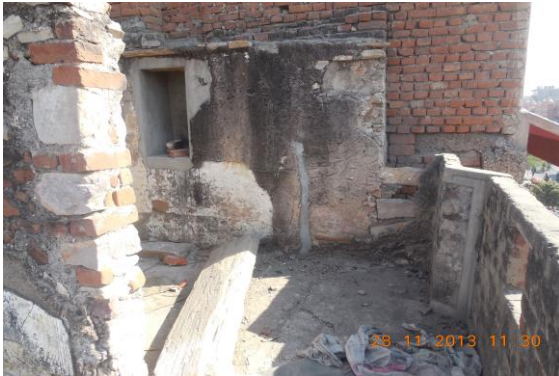
Photo 177

Peeling of Plaster on Terrace of House No. 1902, Upper First Floor

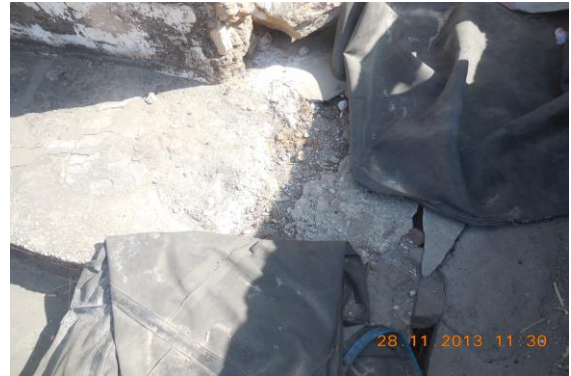
Photo 178

Peeling of Plaster on Terrace of House No. 1902, Upper First Floor

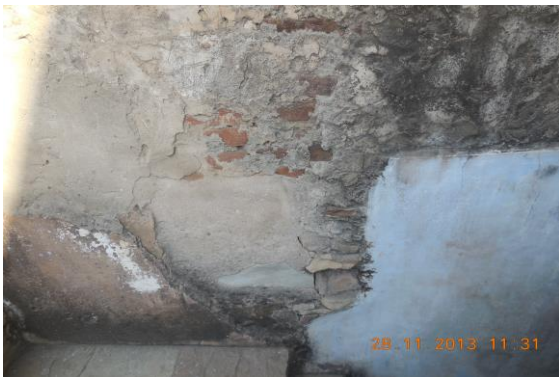
Photo 179

Peeling of Plaster on Terrace of House No. 1902, Upper First Floor

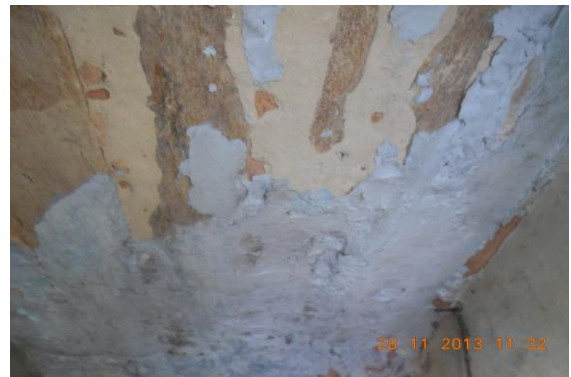
Photo 180

Peeling of Plaster on Terrace of House No. 1902, Upper First Floor

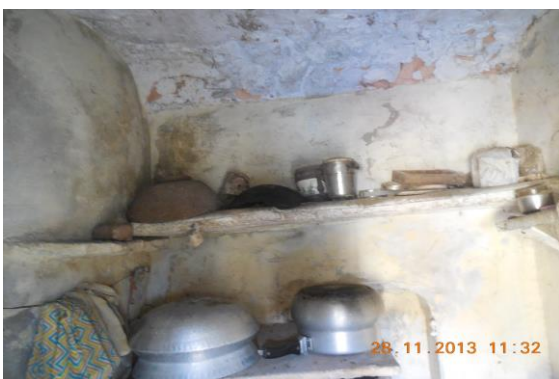
Photo 181

Peeling of Plaster on Floor of Toilet No. 1 of House No. 1902, Upper First Floor

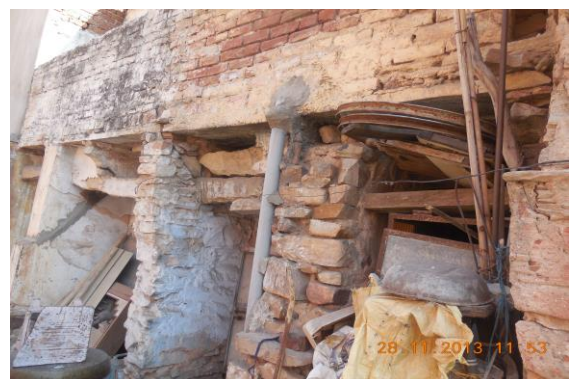
Photo 182

Dampness/Seepage on Wall No. 4 of Toilet No. 1 of House No. 1902, Upper First Floor

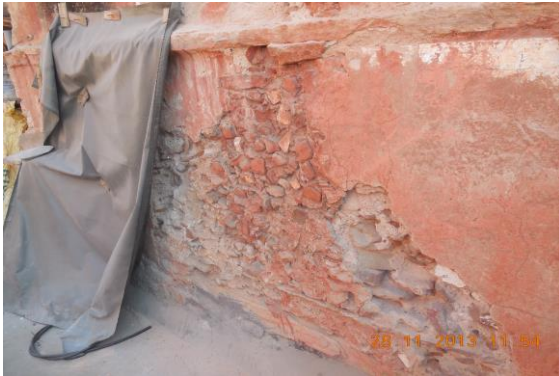
Photo 183

Peeling of Plaster on Front Side of External Façade

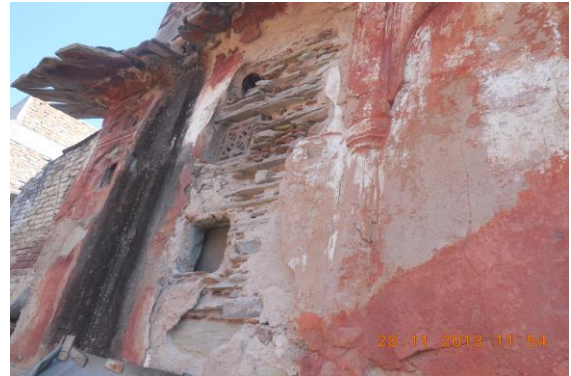
Photo 184  
Peeling of Plaster on Front Side of External Façade

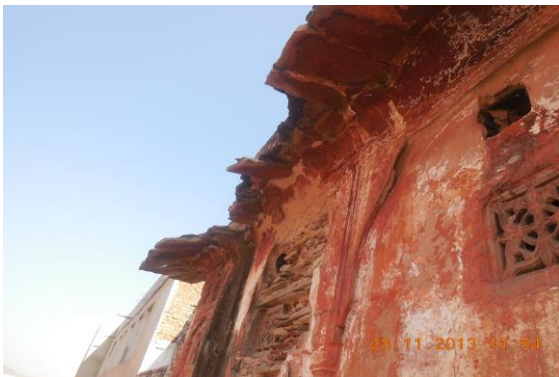
Photo 185  
Peeling of Plaster on Front Side of External Façade

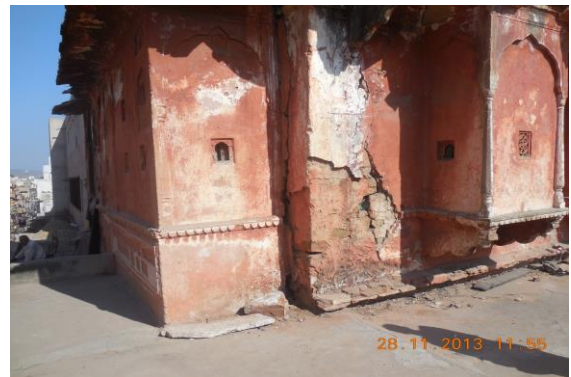
Photo 186  
Peeling of Plaster on Front Side of External Façade

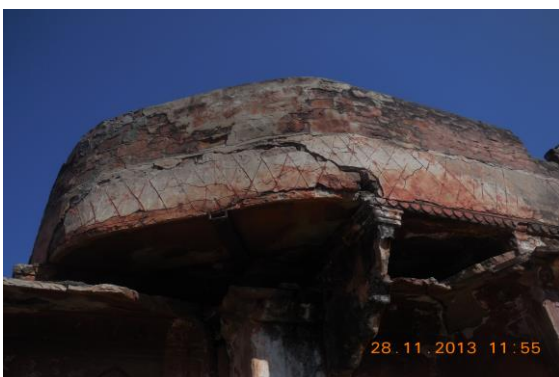
Photo 187  
Peeling of Plaster on Side B of External Façade

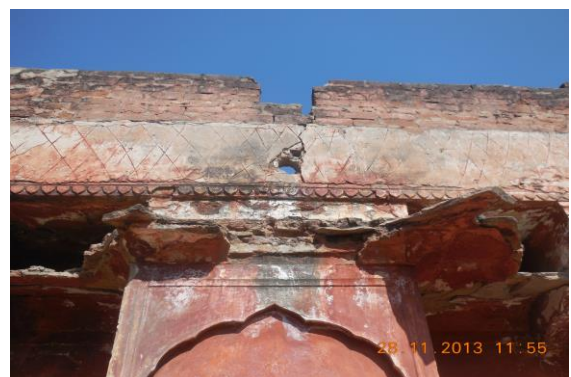
Photo 188  
Peeling of Plaster on Side B of External Façade

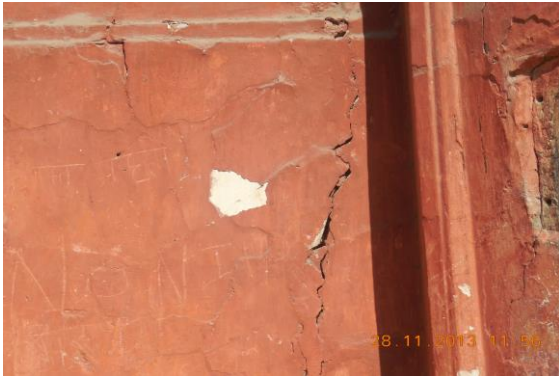
Photo 189  
Peeling of Plaster on Side B of External Façade

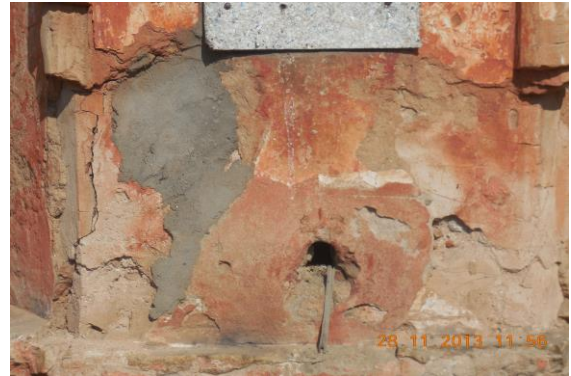
Photo 190  
Peeling of Plaster on of Side B of External Façade

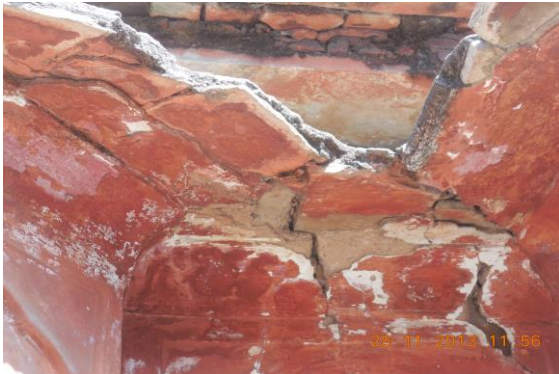
Photo 191  
Peeling of Plaster on of Side B of External Façade

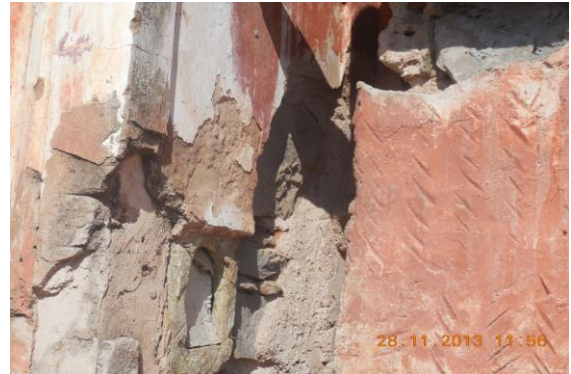
Photo 192  
Peeling of Plaster on of Side B of External Façade

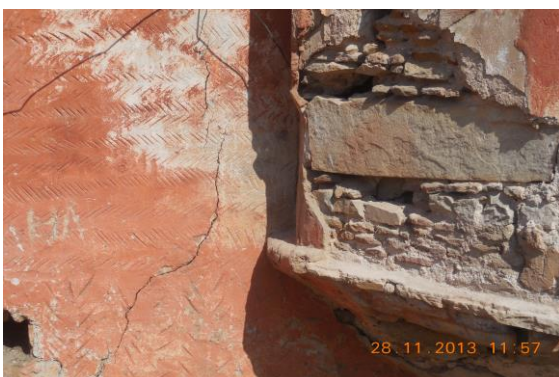
Photo 193  
Peeling of Plaster on of Side B of External Façade

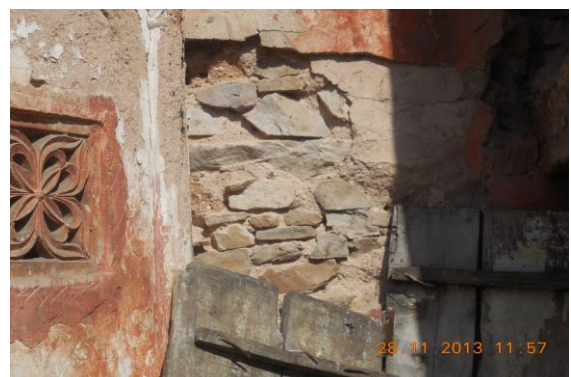
Photo 194  
Peeling of Plaster on of Side B of External Façade

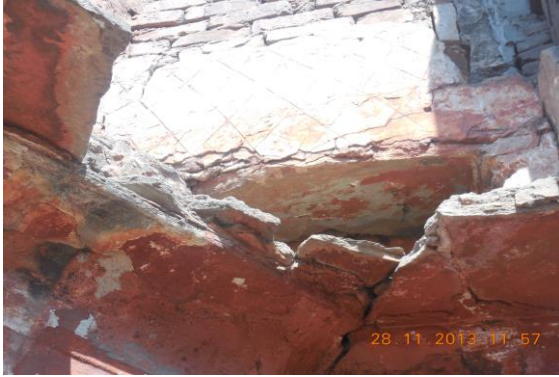
Photo 195  
Peeling of Plaster on of Side B of External Façade

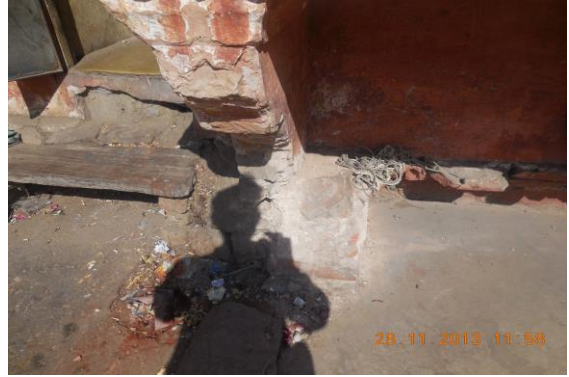
Photo 196  
Peeling of Plaster on Side B of External Façade

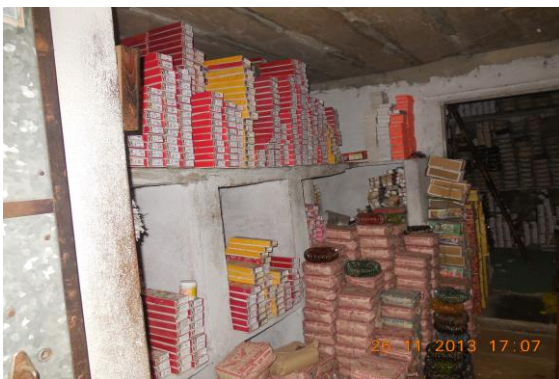
Photo 199  
Wall No. 2 of Shop No.340 of Ground Floor Covered With Material

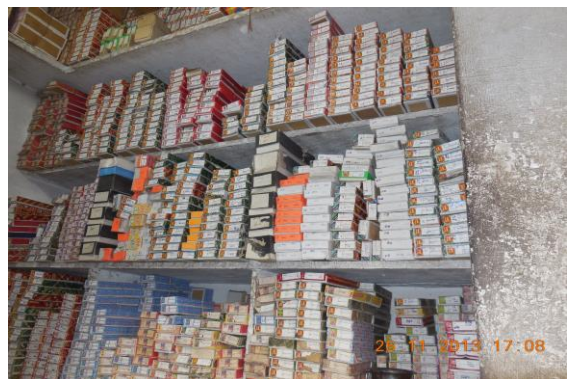
Photo 200  
Wall No. 1 of Shop No.340 of Ground Floor Covered With Material

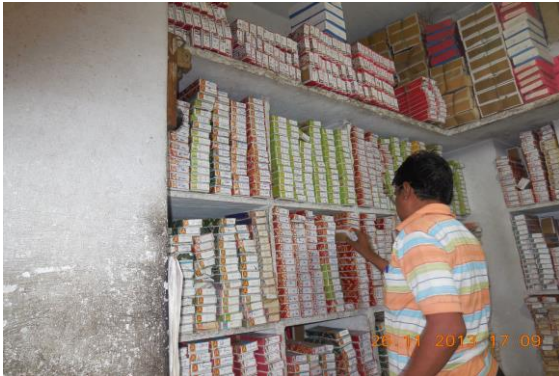
Photo 201  
Wall No. 2 of Shop No.340 of Ground Floor Covered With Material

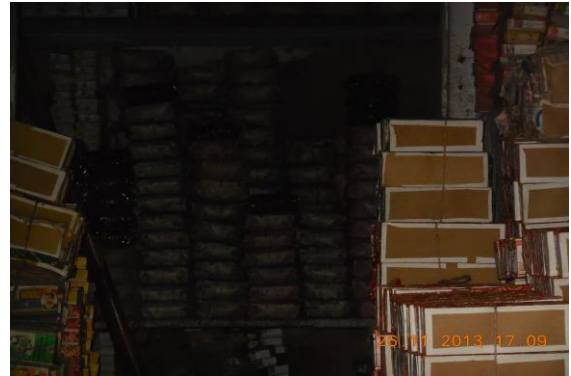
Photo 202

Wall No. 1 of Shop No.340 of Ground Floor Covered With Material

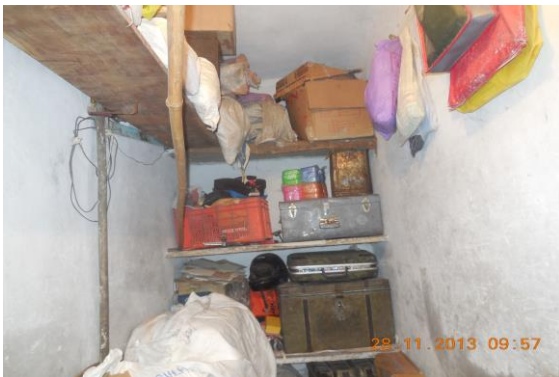
Photo 203

Wall No. 4 of Shop No.340 of Ground Floor Covered With Material

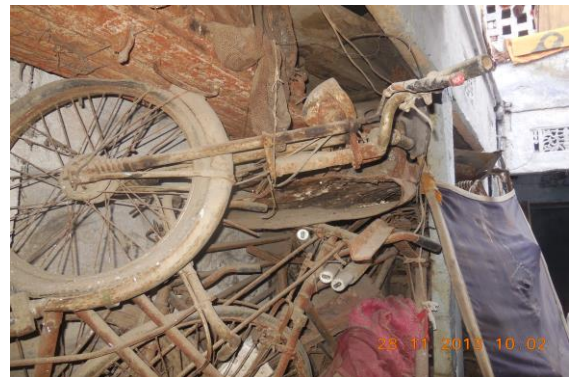
Photo 204

Wall No. 4 of Store 1 of House No. 1902, Ground Floor Covered with Material

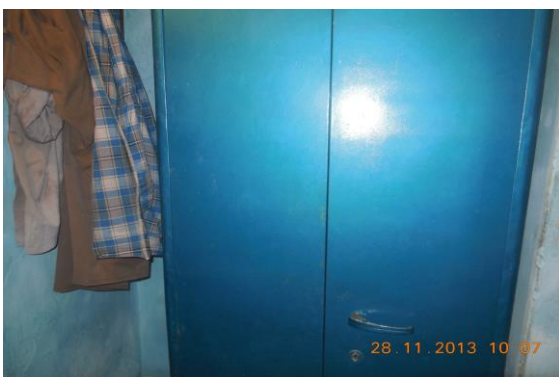
Photo 205

Wall No. 1 of Varanda of House No. 1902, Ground Floor Covered with Material

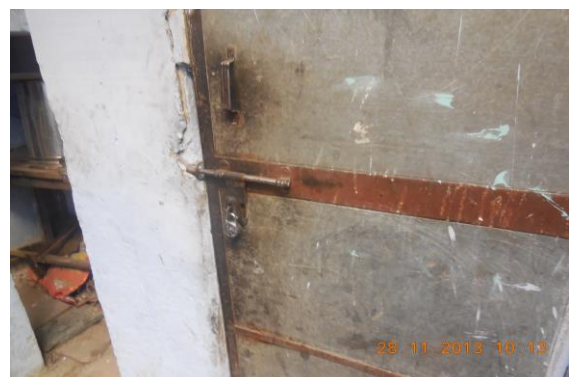
Photo 206

Wall No. 2 of Lobby of House No. 1902, Ground Floor

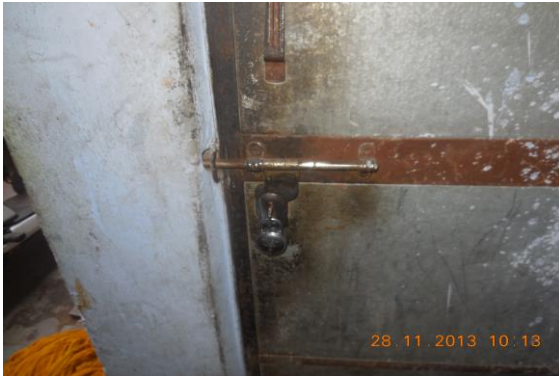
Photo 207

Bathroom of House No. 1902, Ground Floor Locked

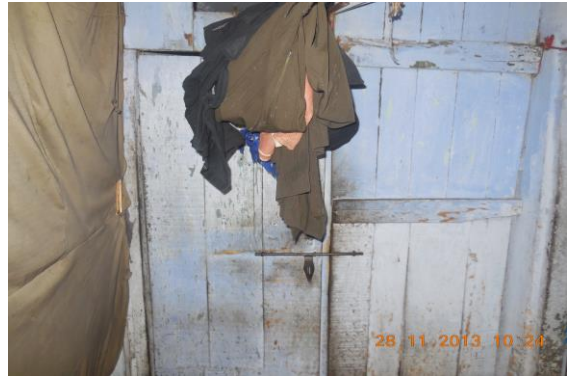
Photo 208  
Toilet No. 1 of House No. 1902, Ground Floor Locked

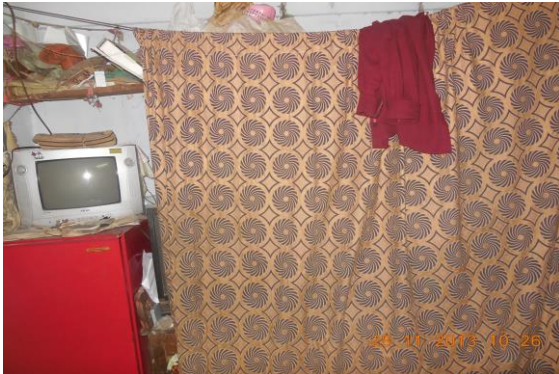
Photo 209  
Wall No. 1 of Varanda 1 of House No. 1902, First Floor Covered with Wood Work

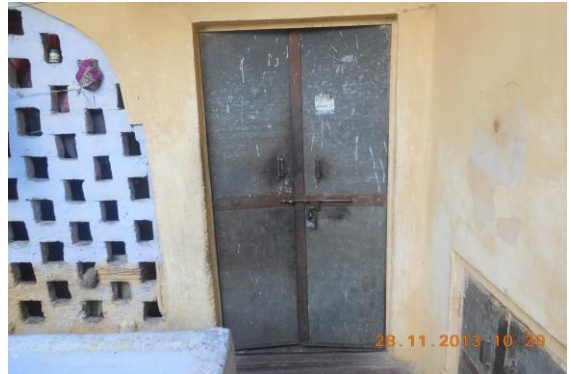
Photo 210  
Wall No. 2 of Varanda 2 of House No. 1902, First Floor Covered with Material

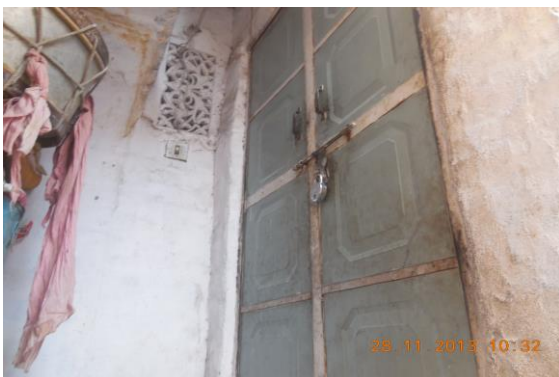
Photo 211  
Varanda 3 of House No. 1902, First Floor Locked

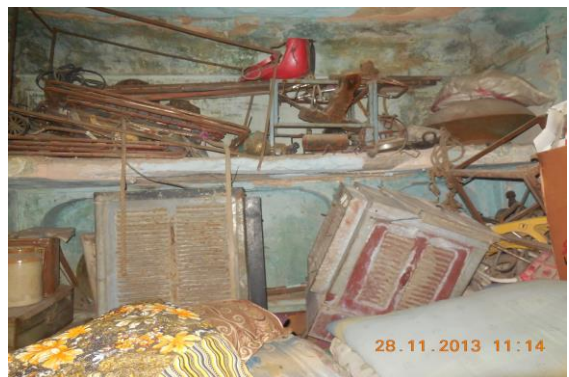
Photo 212  
Tinshed of House No. 1902, Second Floor Locked

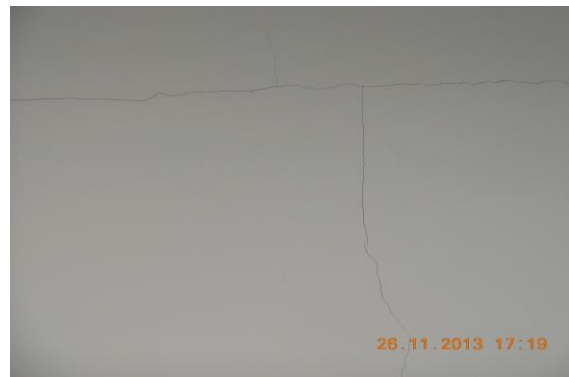
Photo 28

Vertical Crack on Wall No. 4 of Shop No.337 & 338, Basement, Approx. Width = 0.2mm, Approx. Length = 5.5m. Distance from Wall no.1 = 0m, Height from Floor = 2.8m.

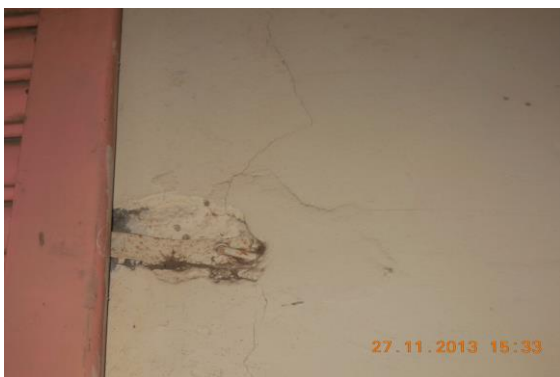
Photo 29

Inclined Crack on Wall No. 2 of Passage, Munshi Shopping Complex, Ground Floor, Approx. Width = 0.2mm, Approx. Length = 1.4m. Distance from Wall No. 3 = 2.2m, Height from Floor = 1.5m.

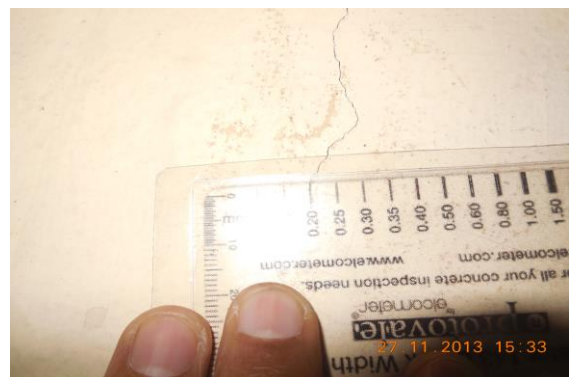
Photo 29A

Inclined Crack on Wall No. 2 of Passage, Munshi Shopping Complex, Ground Floor, Approx. Width = 0.2mm, Approx. Length = 1.4m. Distance from Wall No. 3 = 2.2m, Height from Floor = 1.5m.

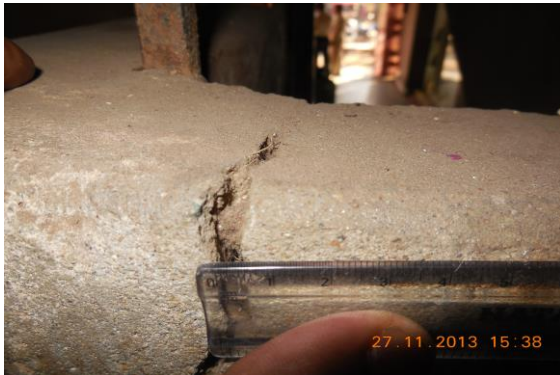
Photo 30

Vertical Crack on Parapet Wall of Stair Basement to GF, Munshi Shop. Complex, G. Floor, Approx. Width = 5mm, Approx. Length = 0.3m. Distance from Wall No. 1 = 1.2m, Height from Floor = 0m.

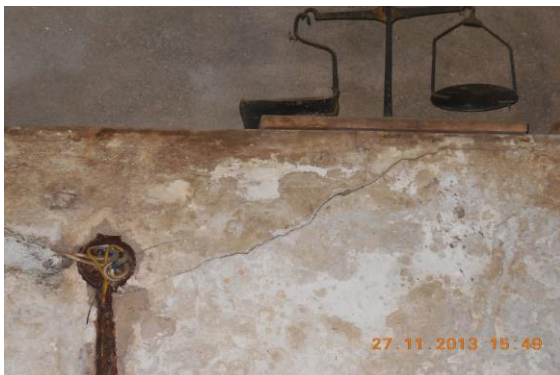
Photo 32

Inclined Crack on Wall No. 4 of Shop No. 5 & 6, Munshi Shopping Complex, Ground Floor, Approx. Width = 2mm, Approx. Length = 0.5m. Distance from Wall No. 2 = 1.5m, Height from Floor = 2.1m.

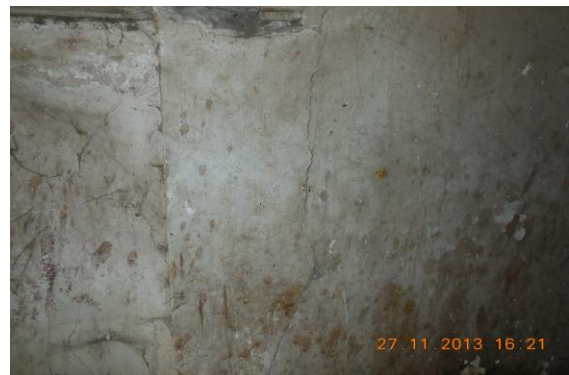
Photo 33

Inclined Crack on Wall No. 4 of Passage, Munshi Shopping Complex, Upper G. Floor, Approx. Width = 1mm, Approx. Length = 0.6m. Distance from Wall No. 1 = 1.3m, Height from Floor = 0.3m.

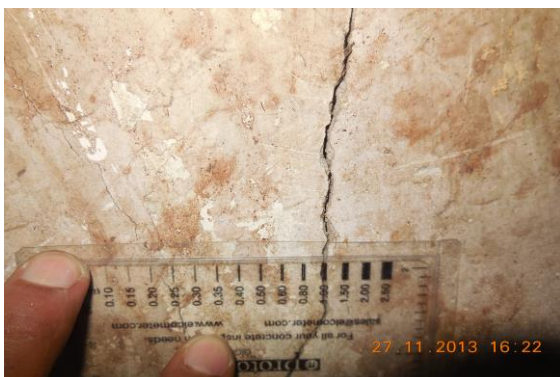
Photo 33A

Inclined Crack on Wall No. 4 of Passage, Munshi Shop. Complex, Upper G. Floor, Approx. Width = 1mm, Approx. Length = 0.6m. Distance from Wall No. 1 = 1.3m, Height from Floor = 0.3m.

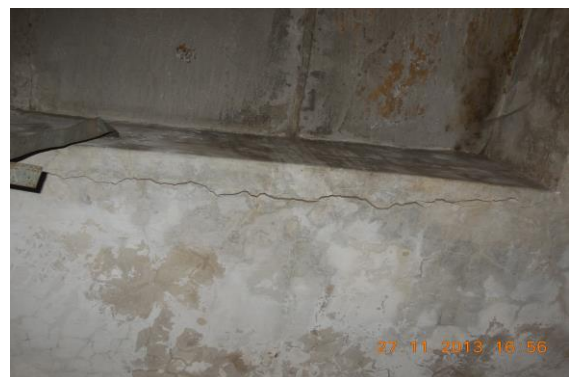
Photo 34

Horizontal Crack on Roof of Passage 1, Munshi Shopping Complex, Second Floor, Approx. Width = 3mm, Approx. Length = 1.1m. Distance from Wall No. 2 = 1.1m, Height from Floor = 3m.

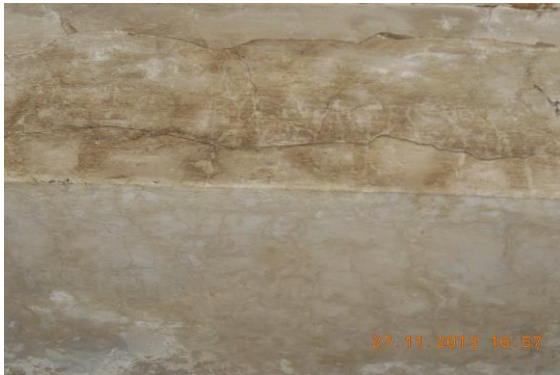
Photo 35

Horizontal Crack on Roof of Passage 1, Munshi Shopping Complex, Second Floor, Approx. Width = 1mm, Approx. Length = 1.1m. Distance from Wall No. 3 = 0m, Height from Floor = 3m.

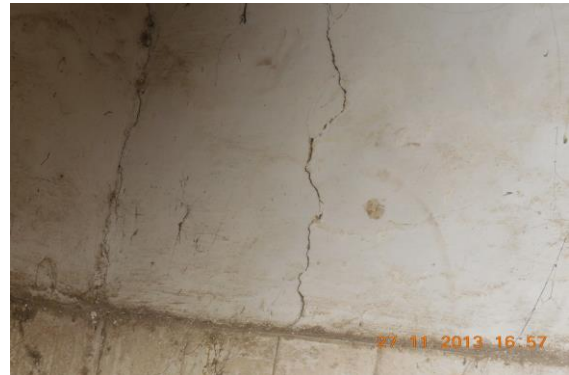
Photo 36

Inclined Crack on Wall No. 4 of Bathroom, Munshi Shopping Complex, Second Floor, Approx. Width = 1.5mm, Approx. Length = 0.7m. Distance from Wall No. 1 = 0.2m, Height from Floor = 1.5m.

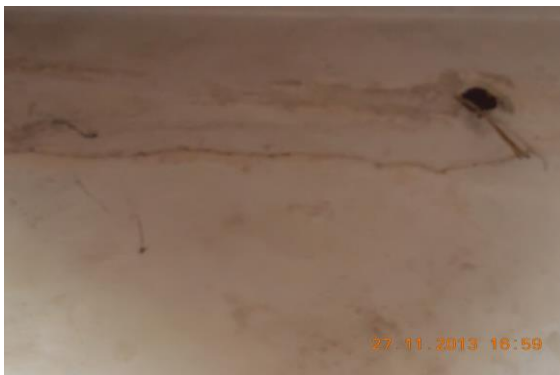
Photo 37

Horizontal Crack on Wall No. 4 of Toilet No. 1, Munshi Shopping Complex, Second Floor, Approx. Width = 0.35mm, Approx. Length = 1m. Distance from Wall No. 1 = 0m, Height from Floor = 2.8m.

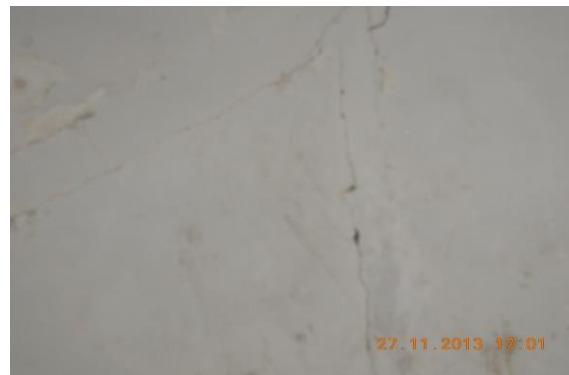
Photo 38

Inclined Crack on Wall No. 3 of Hall No. 1, Munshi Shopping Complex, Second Floor, Approx. Width = 1mm, Approx. Length = 5m. Distance from Wall No. 2 = 1.3m, Height from Floor = 0m.

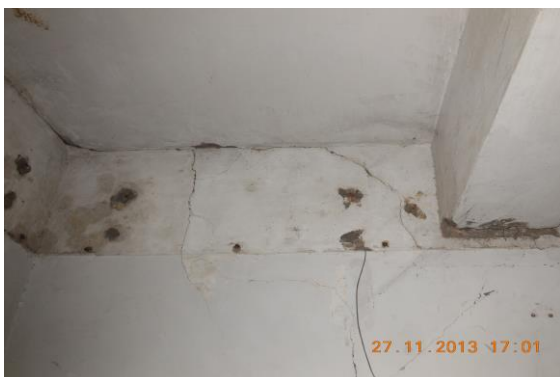
Photo 39

Inclined Crack on Wall No. 3 of Hall No. 1, Munshi Shopping Complex, Second Floor, Approx. Width = 1mm, Approx. Length = 5m. Distance from Wall No. 2 = 1.3m, Height from Floor = 0m.

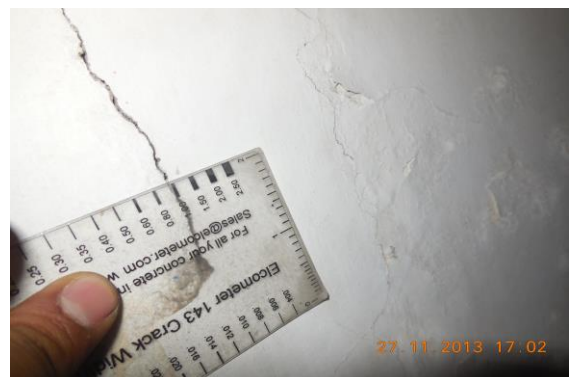
Photo 39A

Inclined Crack on Wall No. 3 of Hall No. 1, Munshi Shopping Complex, Second Floor, Approx. Width = 1mm, Approx. Length = 5m. Distance from Wall No. 2 = 1.3m, Height from Floor = 0m.

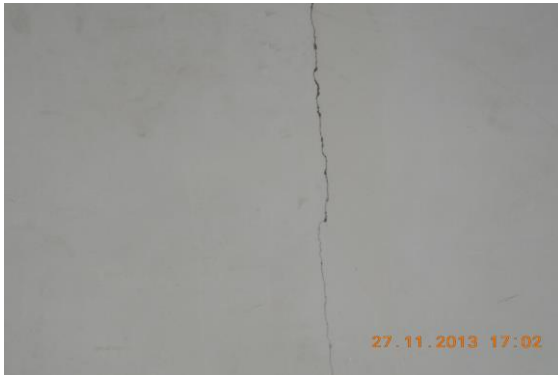
Photo 40

Vertical Crack on Wall No. 3 of Hall No. 1, Munshi Shopping Complex, Second Floor, Approx. Width = 0.8mm, Approx. Length = 1.5m. Distance from Wall No. 2 = 1.7m, Height from Floor = 0.6m.

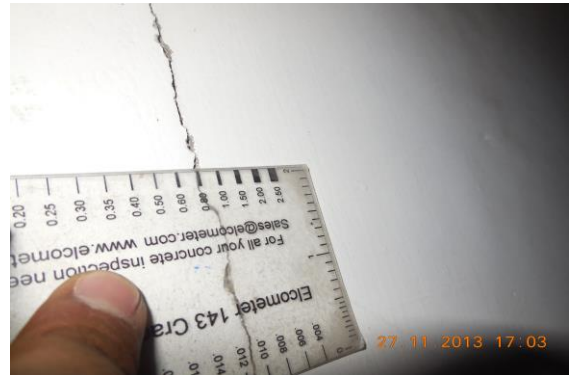
Photo 40A

Vertical Crack on Wall No. 3 of Hall No. 1, Munshi Shopping Complex, Second Floor, Approx. Width = 0.8mm, Approx. Length = 1.5m. Distance from Wall No. 2 = 1.7m, Height from Floor = 0.6m.

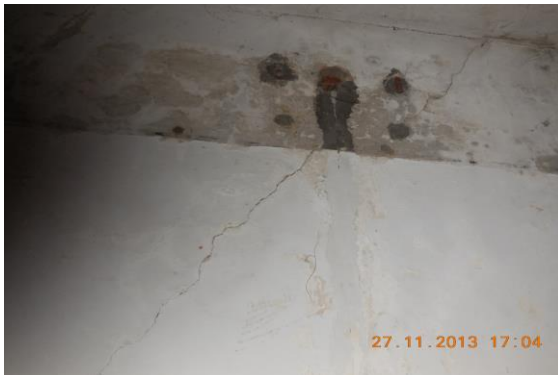
Photo 41

Inclined Crack on Wall No. 2 of Hall No. 1, Munshi Shopping Complex, Second Floor, Approx. Width = 0.6mm, Approx. Length = 1.65m. Distance from Wall No. 4 = 3.7m, Height from Floor = 1.6m.

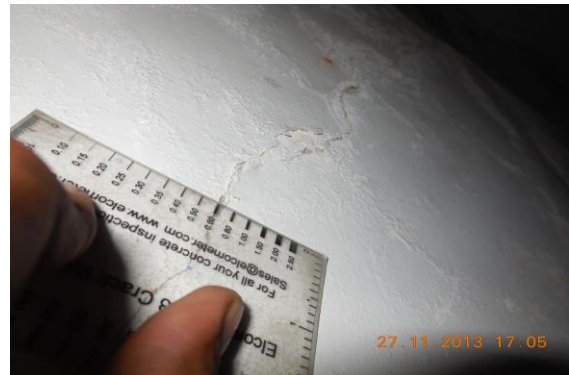
Photo 41A

Inclined Crack on Wall No. 2 of Hall No. 1, Munshi Shopping Complex, Second Floor, Approx. Width = 0.6mm, Approx. Length = 1.65m. Distance from Wall No. 4 = 3.7m, Height from Floor = 1.6m.

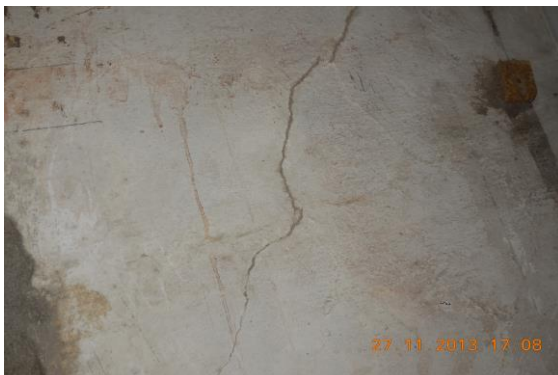
Photo 42

Inclined Crack on Wall No. 2 of Hall No. 1, Munshi Shopping Complex, Second Floor, Approx. Width = 0.8mm, Approx. Length = 3.2m. Distance from Wall No. 4 = 2m, Height from Floor = 0.5m.
