### Pre Building Condition Survey Report

Name and Address of Structure :	Badi Chopar to Ramp Area (UP Line)
---------------------------------	------------------------------------

Name of the Project	<b>Contract JMRC-UG1B</b> “Design and Construction of Tunnel between Chandpole and Badi Chouper and reverse line by Shield TBM, Underground Metro Stations at Choti Chouper and Badi Chouper by Cut and Cover Methods on East West Corridor of Jaipur Metro Rail Corporation Limited .”	
Owner :

Pre Building Condition Survey Report Badi Chopar to Ramp Area (UP Line)

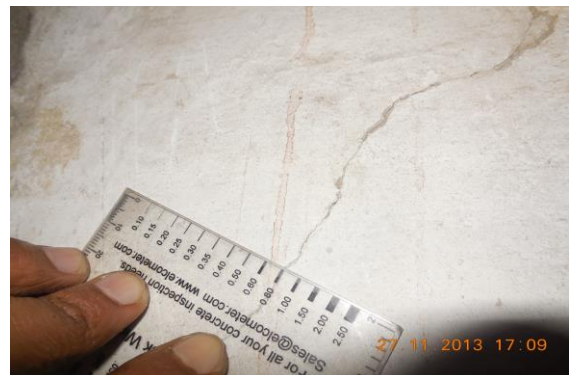
Photo 42A

Inclined Crack on Wall No. 2 of Hall No. 1, Munshi Shopping Complex, Second Floor, Approx. Width = 0.8mm, Approx. Length = 3.2m. Distance from Wall No. 4 = 2m, Height from Floor = 0.5m.

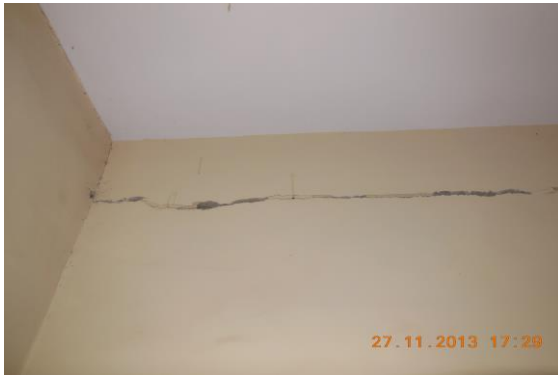
Photo 43

Horizontal Crack on Wall No. 1 of Toilet No. 1, Munshi Shopping Complex, Second Floor, Approx. Width = 10mm, Approx. Length = 2m. Distance from Wall No. 3 = 0m, Height from Floor = 3m.

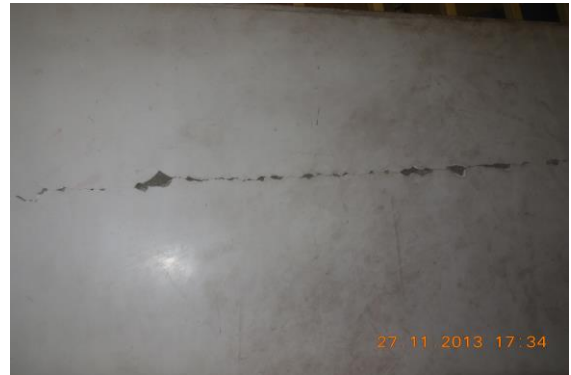
Photo 44

Vertical Crack on Wall No. 1 & 4 of Stair Inside Shop FF to SF Steps, Munshi Shop. Complex, S. Floor, App. Width = 0.35mm, App. Length = 2.5m. Distance Wall No. 3 = 0.4m, Height Floor = 1.5m.

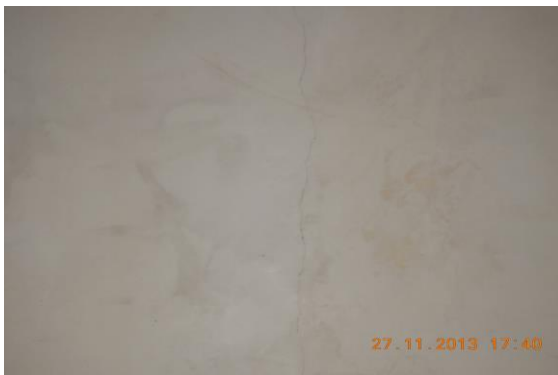
Photo 45

Vertical Crack on Wall No. 1 of Hall No. 1, Munshi Shopping Complex, Third Floor, Approx. Width = 0.15mm, Approx. Length = 3.3m. Distance from Wall No. 4 = 1.5m, Height from Floor = 0m.

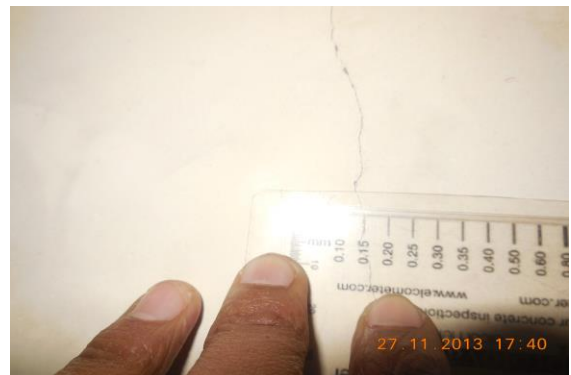
Photo 45A

Vertical Crack on Wall No. 1 of Hall No. 1, Munshi Shopping Complex, Third Floor, Approx. Width = 0.15mm, Approx. Length = 3.3m. Distance from Wall No. 4 = 1.5m, Height from Floor = 0m.

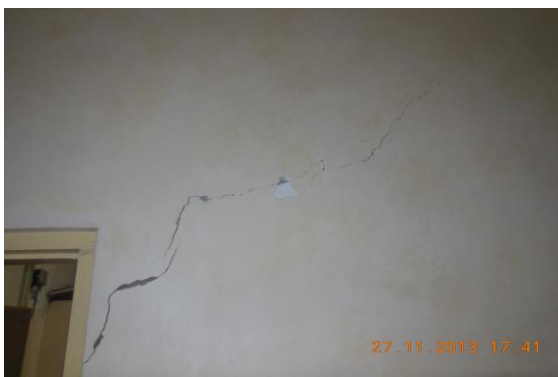
Photo 46

Inclined Crack on Wall No. 2 of Hall No. 1, Munshi Shopping Complex, Third Floor, Approx. Width = 1.5mm, Approx. Length = 2.3m. Distance from Wall No. 4 = 1m, Height from Floor = 1.5m.

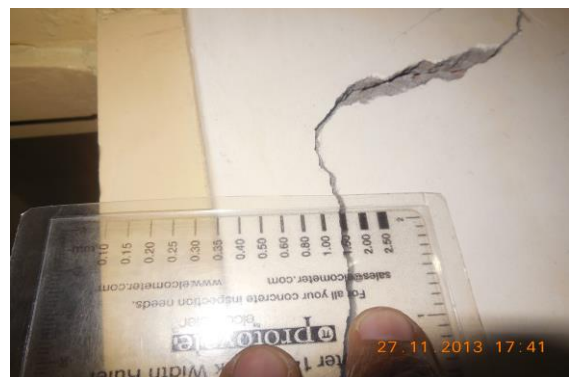
Photo 46A

Inclined Crack on Wall No. 2 of Hall No. 1, Munshi Shopping Complex, Third Floor, Approx. Width = 1.5mm, Approx. Length = 2.3m. Distance from Wall No. 4 = 1m, Height from Floor = 1.5m.

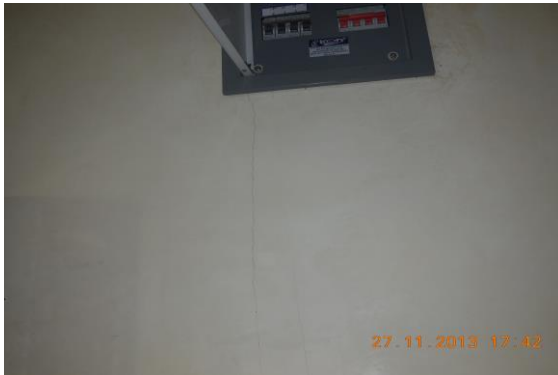
Photo 47

Vertical Crack on Wall No. 2 of Hall No. 1, Munshi Shopping Complex, Third Floor, Approx. Width = 0.15mm, Approx. Length = 3.5m. Distance from Wall No. 4 = 5m, Height from Floor = 1.3m.

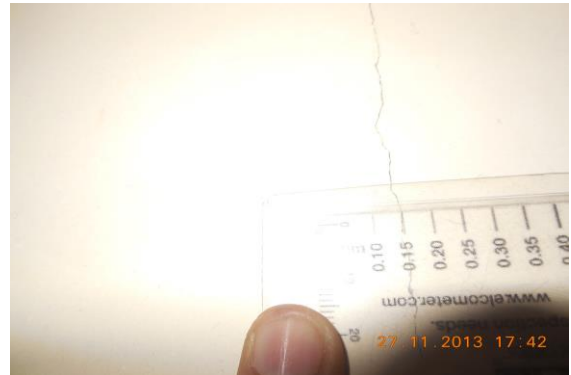
Photo 47A

Vertical Crack on Wall No. 2 of Hall No. 1, Munshi Shopping Complex, Third Floor, Approx. Width = 0.15mm, Approx. Length = 3.5m. Distance from Wall No. 4 = 5m, Height from Floor = 1.3m.

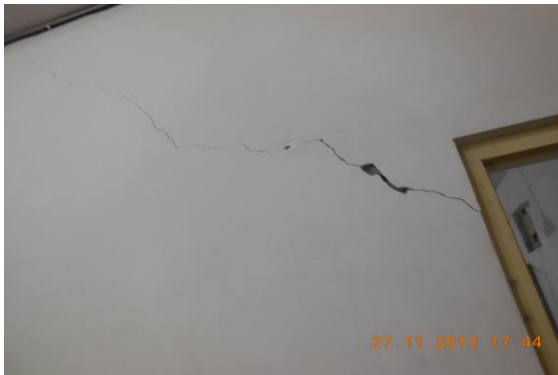
Photo 48

Inclined Crack on Wall No. 3 of Room No. 1, Munshi Shopping Complex, Third Floor, Approx. Width = 11mm, Approx. Length = 1.7m. Distance from Wall No. 2 = 1m, Height from Floor = 2m.

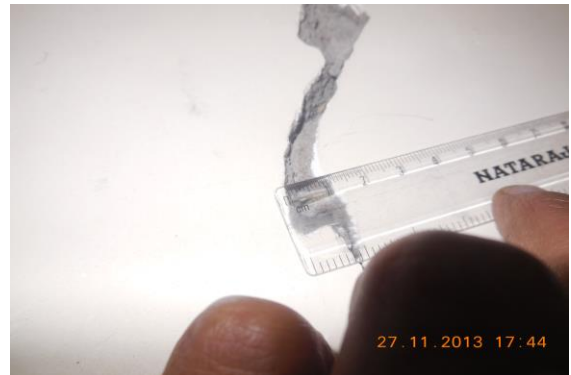
Photo 48A

Inclined Crack on Wall No. 3 of Room No. 1, Munshi Shopping Complex, Third Floor, Approx. Width = 11mm, Approx. Length = 1.7m. Distance from Wall No. 2 = 1m, Height from Floor = 2m.

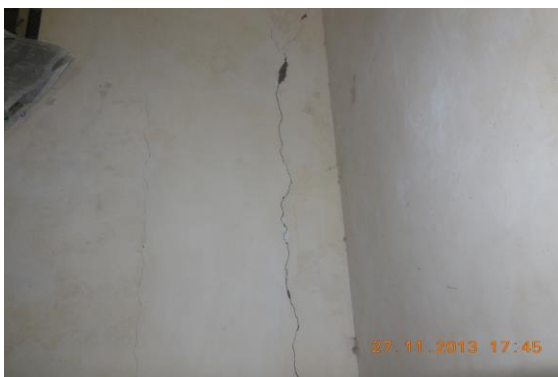
Photo 49

Vertical Crack on Wall No. 1 of Room No. 1, Munshi Shopping Complex, Third Floor, Approx. Width = 2.5mm, Approx. Length = 1.35m. Distance from Wall No. 4 = 0.15m, Height from Floor = 1.2m.

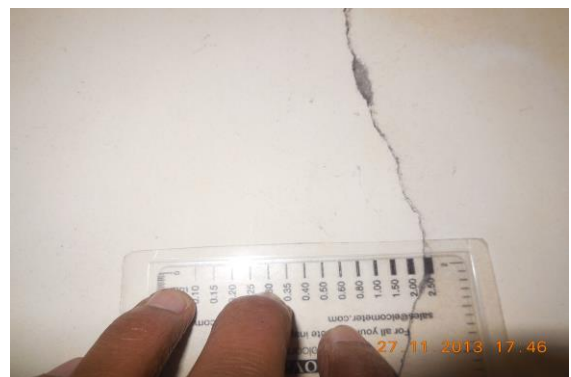
Photo 49A

Vertical Crack on Wall No. 1 of Room No. 1, Munshi Shopping Complex, Third Floor, Approx. Width = 2.5mm, Approx. Length = 1.35m. Distance from Wall No. 4 = 0.15m, Height from Floor = 1.2m.

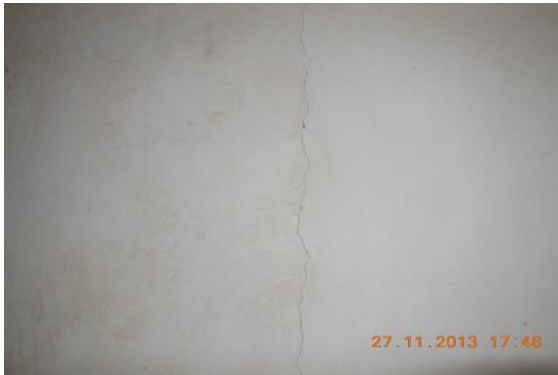
Photo 50

Vertical Crack on Wall No. 1 of Room No. 1, Munshi Shopping Complex, Third Floor, Approx. Width = 0.15mm, Approx. Length = 1.35m. Distance from Wall No.4 = 0.4m, Height from Floor = 1.2m.

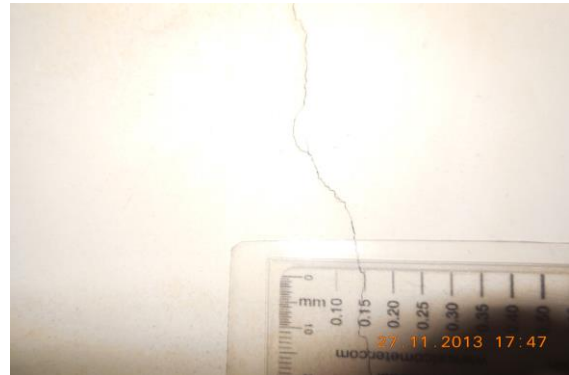
Photo 50A

Vertical Crack on Wall No. 1 of Room No. 1, Munshi Shopping Complex, Third Floor, Approx. Width = 0.15mm, Approx. Length = 1.35m. Distance from Wall No.4 = 0.4m, Height from Floor = 1.2m.

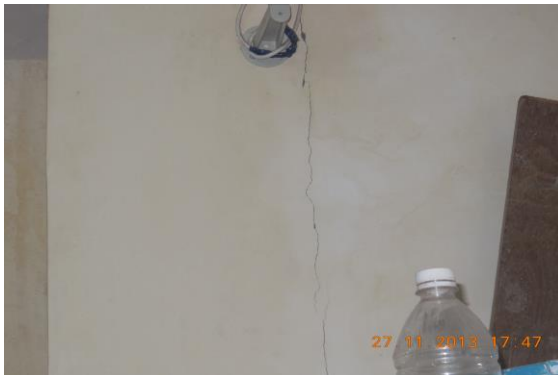
Photo 51

Vertical Crack on Wall No. 4 of Room No. 1, Munshi Shopping Complex, Third Floor, Approx. Width = 2mm, Approx. Length = 1.5m. Distance from Wall No. 2 = 0.5m, Height from Floor = 2m.

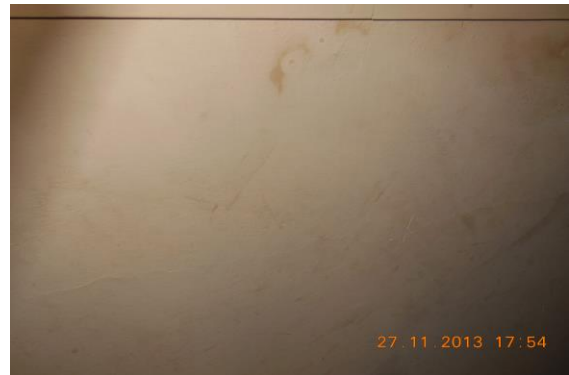
Photo 52

Horizontal Crack on Wall No. 2 of Stair 1 SF to Third Floor, Munshi Shop. Complex, T.Floor, Approx. Width = 0.2mm, Approx. Length = 3m. Distance from Wall No. 3 = 0.8m, Height from Floor = 1.7m.

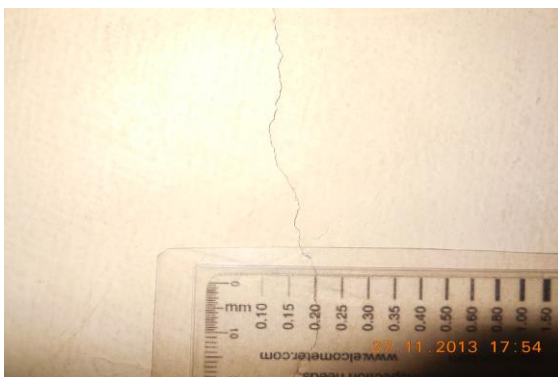
Photo 52A

Horizontal Crack on Wall No. 2 of Stair 1 SF to Third Floor, Munshi Shop. Complex, T. Floor, Approx. Width = 0.2mm, Approx. Length = 3m. Distance from Wall No. 3 = 0.8m, Height from Floor = 1.7m.

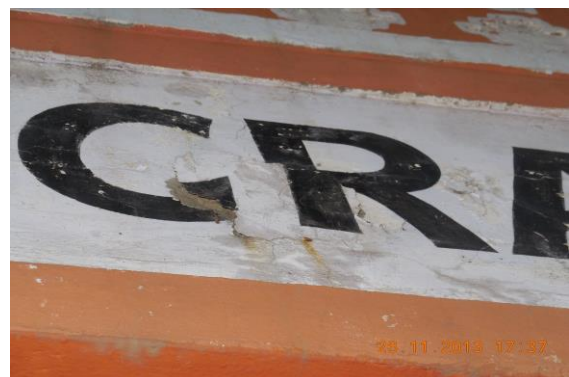
Photo 53

Peeling of Plaster on Outer Wall Column of Varanda of Shop No.335, Ground Floor

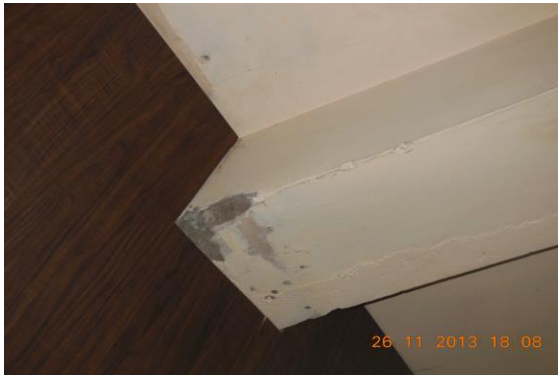
Photo 54

Peeling of Plaster on Roof of Passage No.1 of Ground Floor

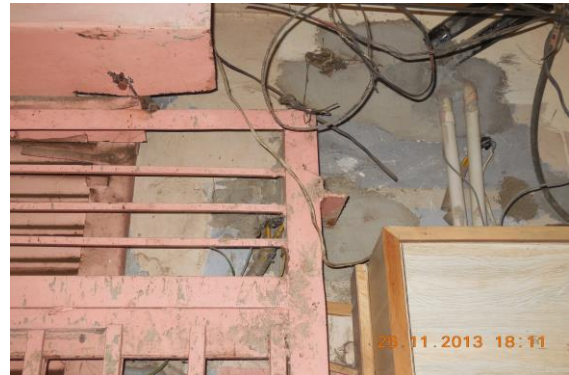
Photo 55

Peeling of Plaster on Wall No. 2 of Passage No.1 of Ground Floor

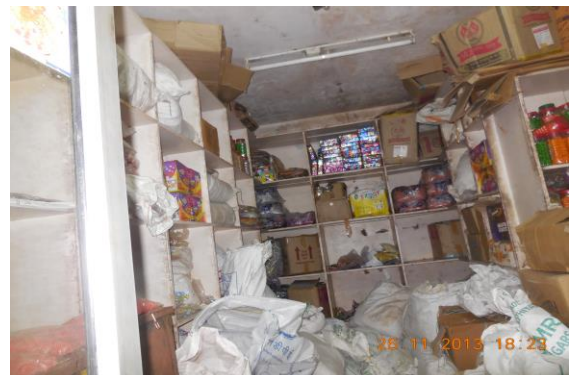
Photo 56

Dampness/Seepage on Wall No. 4 of Passage No.2 of Basement

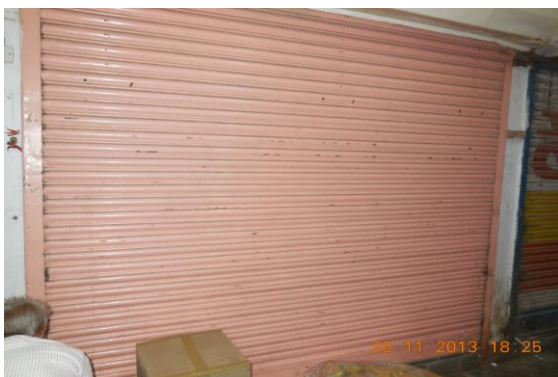
Photo 57

Dampness/Seepage on Roof of Shop No.27 of Basement

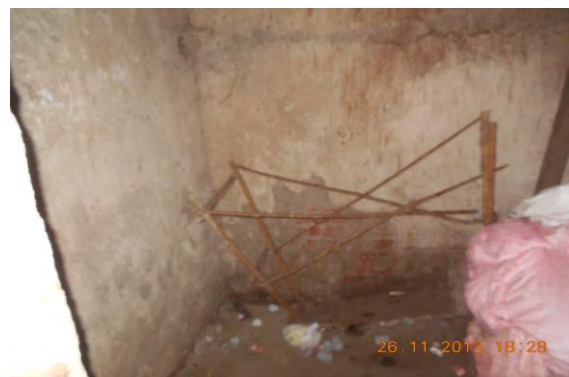
Photo 58

Peeling of Plaster on Wall No. 3 of Shop No.27 of Basement

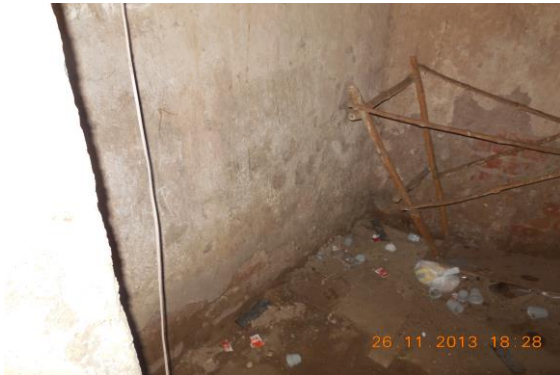
Photo 59

Peeling of Plaster on Wall No. 4 of Shaft A Area of Basement

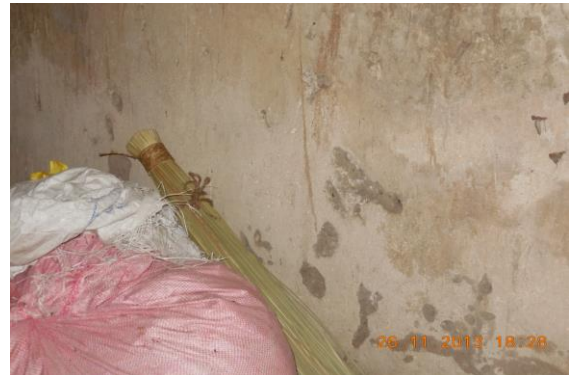
Photo 60

Peeling of Plaster on Wall No. 1 of Shaft A Area of Basement

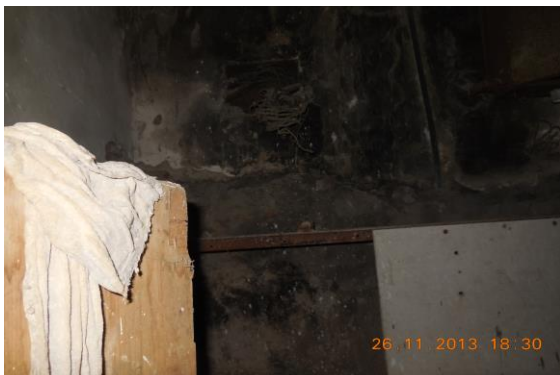
Photo 61

Peeling of Plaster on Wall No. 2 of Shaft A Area of Basement

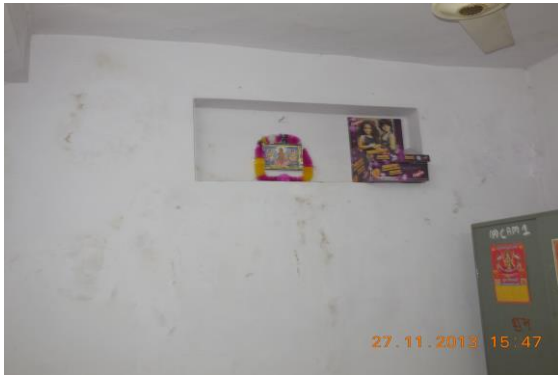
Photo 65

Dampness/Seepage on Wall No. 4 & 2 of Shop No. 7 of Munshi Shopping Complex, Ground Floor

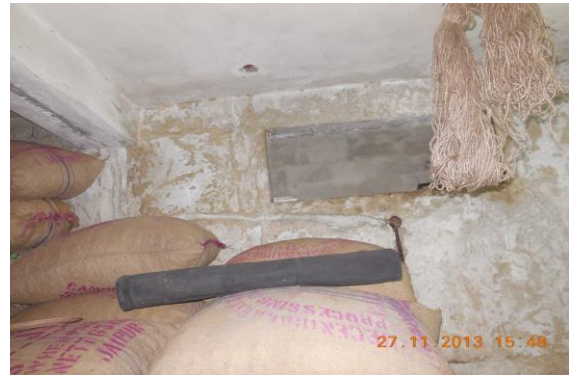
Photo 66

Dampness/Seepage on Wall No. 4 of Shop No. 8 of Munshi Shopping Complex, Ground Floor

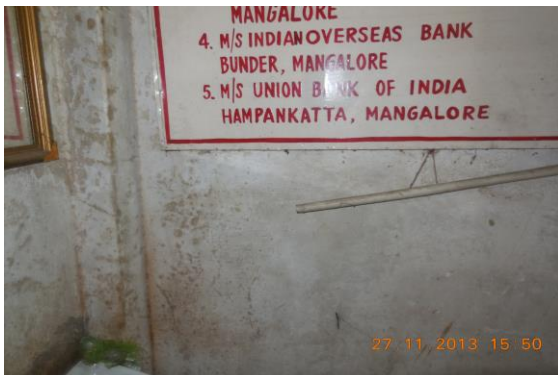
Photo 67

Dampness/Seepage on Wall No. 4 of Shop No. 5 & 6 of Munshi Shopping Complex, Ground Floor

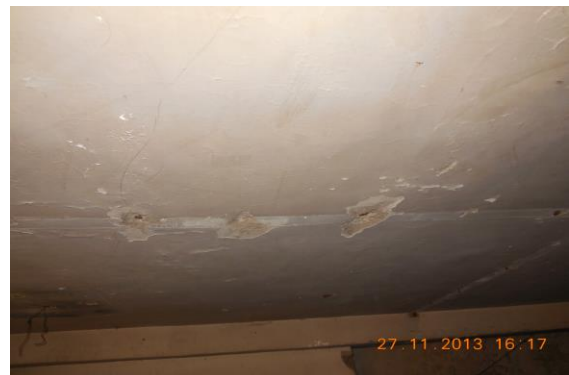
Photo 68

Dampness/Seepage on Wall No. 2 of Shop No. 5 & 6 of Munshi Shopping Complex, Ground Floor

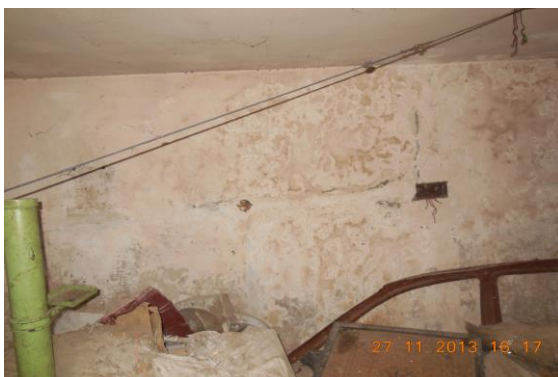
Photo 69

Peeling of Plaster on Roof of Hall No. 1 of Munshi Shopping Complex, Upper Ground Floor

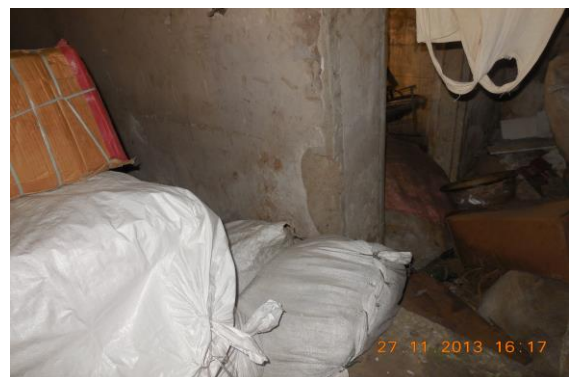
Photo 70

Dampness/Seepage on Wall No. 4 of Hall No. 1 of Munshi Shopping Complex, Upper Ground Floor

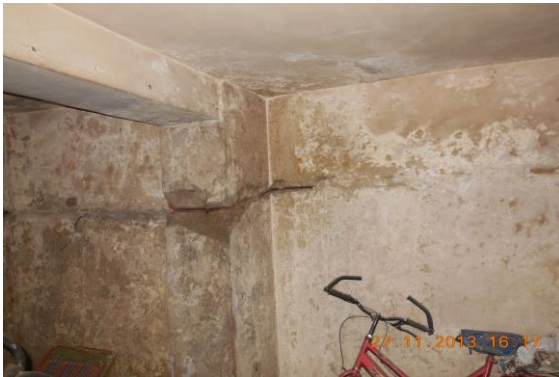
Photo 71

Peeling of Plaster on Wall No. 5 of Hall No. 1 of Munshi Shopping Complex, Upper Ground Floor

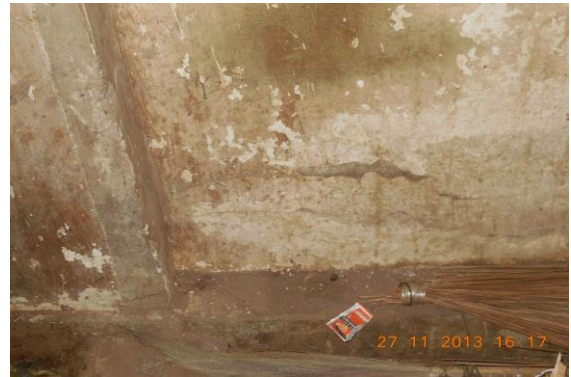
Photo 72

Dampness/Seepage on Wall No. 2 of Hall No. 1 of Munshi Shopping Complex, Upper Ground Floor

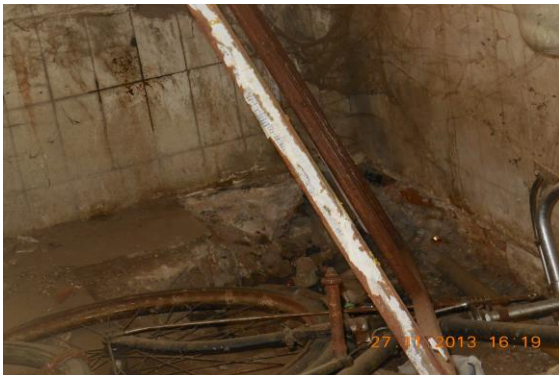
Photo 73

Peeling of Plaster on Wall No. 1 of Hall No. 1 of Munshi Shopping Complex, Upper Ground Floor

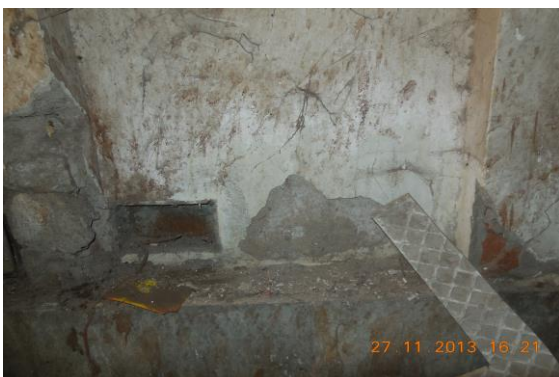
Photo 75

Peeling of Plaster on Wall No. 3 of Hall No. 1 of Munshi Shopping Complex, Upper Ground Floor

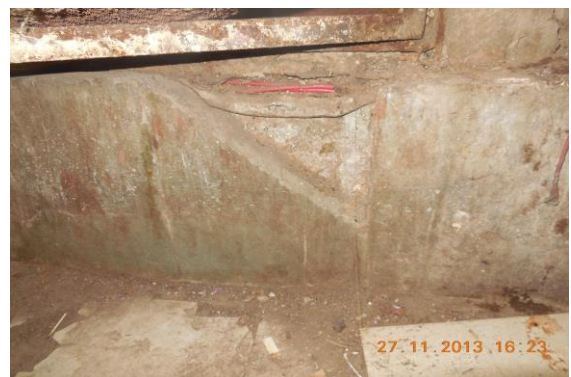
Photo 76

Peeling of Plaster on Wall No. 4 of Passage of Munshi Shopping Complex, Upper Ground Floor

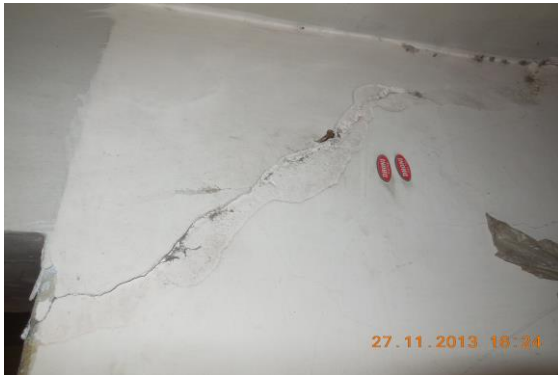
Photo 77

Damaged Portion on Wall No. 4 of Passage of Munshi Shopping Complex, Upper Ground Floor

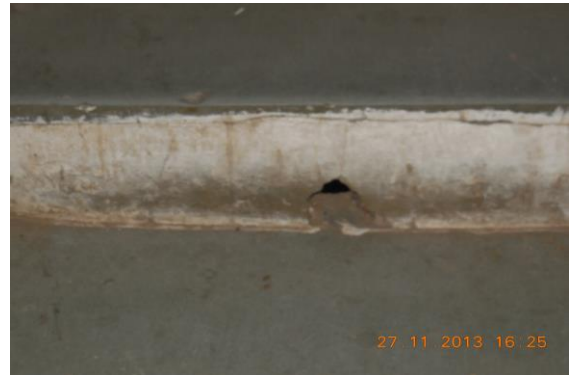
Photo 78

Plaster Crack on Wall No. 2 of Passage of Munshi Shopping Complex, Upper Ground Floor

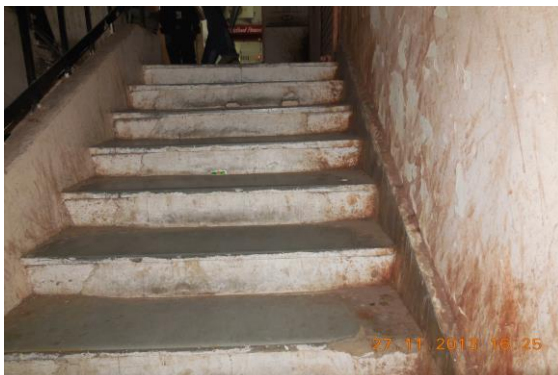
Photo 79

Damaged Portion of Stair UGF to FF Steps of Munshi Shopping Complex, First Floor

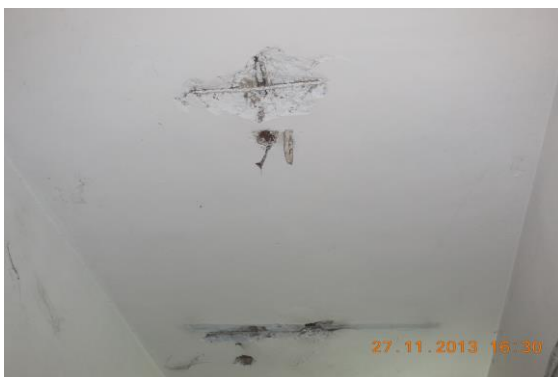
Photo 81

Dampness/Seepage on Roof of Passage of Munshi Shopping Complex, First Floor

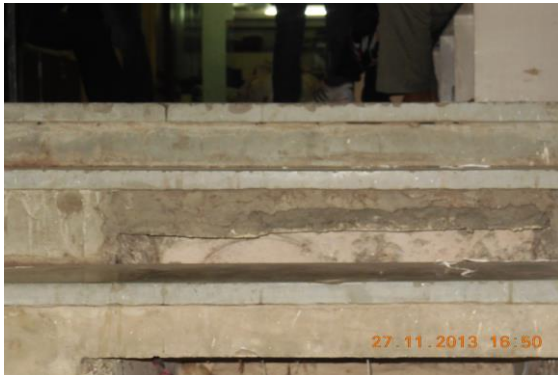
Photo 83

Damaged Portion of Stair FF to SF Steps of Munshi Shopping Complex, Second Floor

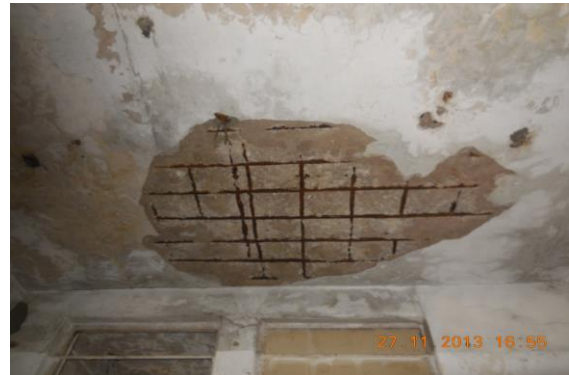
Photo 84  
Damaged Portion of Stair FF to SF Steps of Munshi Shopping Complex, Second Floor

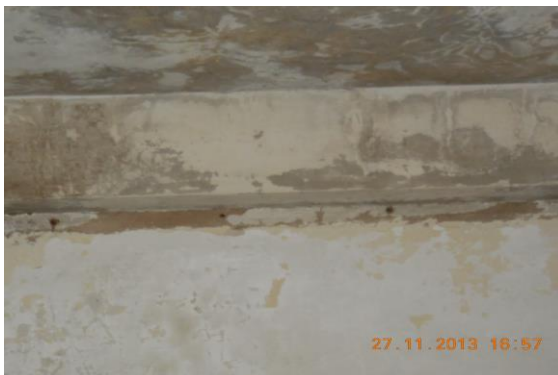
Photo 85  
Exposed Reinforcement on Roof of Passage 1 of Munshi Shopping Complex, Second Floor

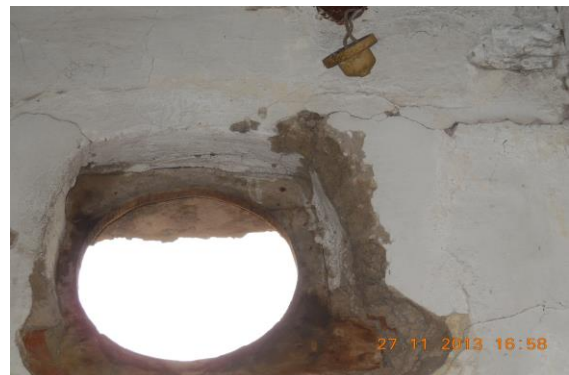
Photo 86  
Dampness/Seepage on Wall No. 2 of Passage 1 of Munshi Shopping Complex, Second Floor

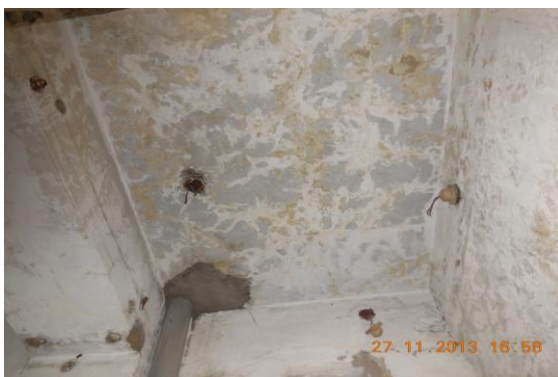
Photo 87  
Damaged Portion on Wall No. 4 of Bathroom of Munshi Shopping Complex, Second Floor

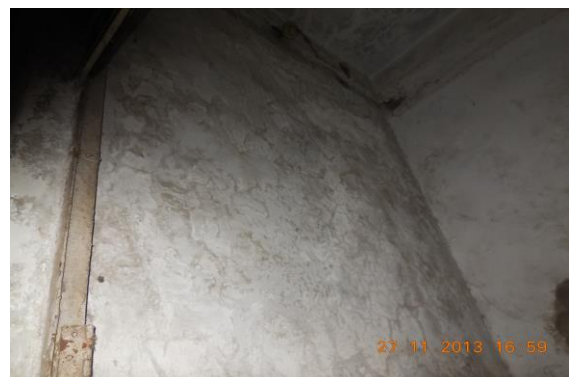
Photo 88  
Dampness/Seepage on Roof of Bathroom of Munshi Shopping Complex, Second Floor

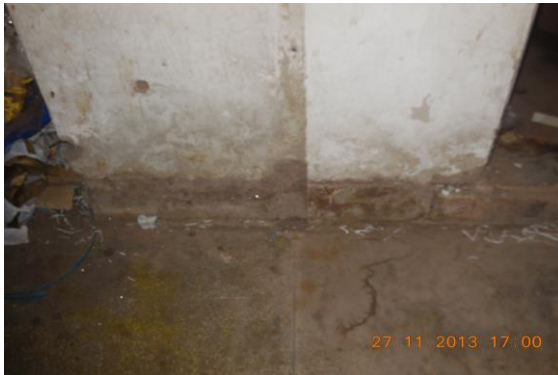
Photo 89  
Dampness/Seepage on Wall No. 1 of Toilet No. 1 of Munshi Shopping Complex, Second Floor

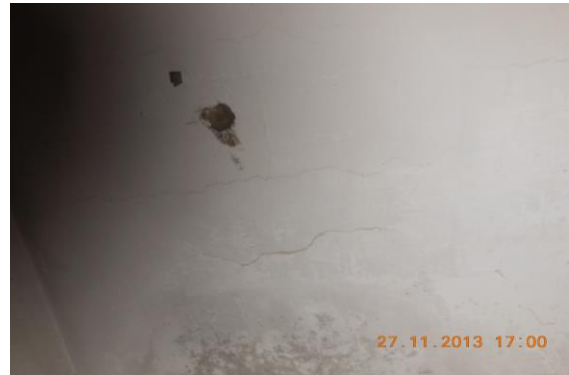
Photo 90

Damaged Portion on Wall No. 4 of Passage 1 of Munshi Shopping Complex, Second Floor

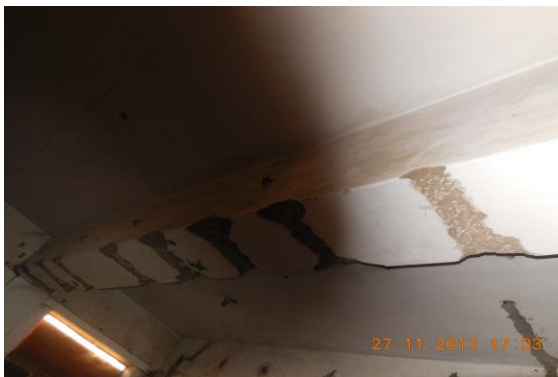
Photo 91

Plaster Crack on Roof of Hall No. 1 of Munshi Shopping Complex, Second Floor

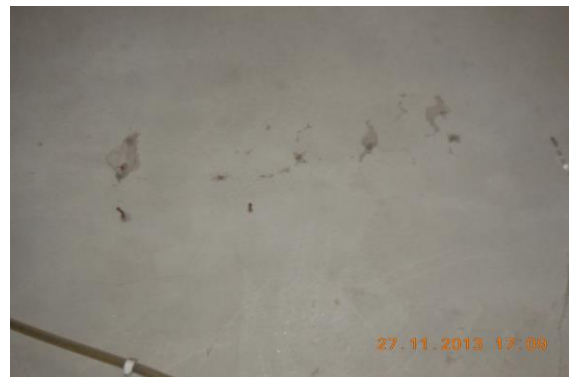
Photo 92

Damaged Portion on Roof of Hall No. 1 of Munshi Shopping Complex, Second Floor

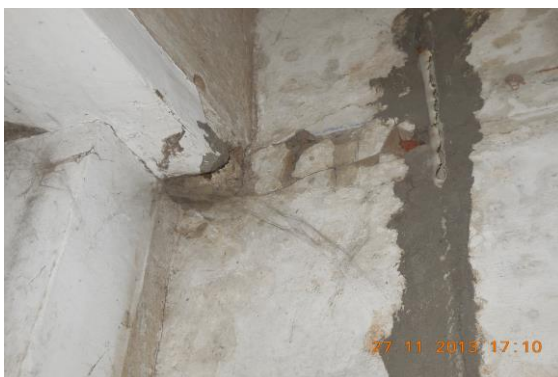
Photo 93

Damaged Portion on Wall No. 1 of Hall No. 1 of Munshi Shopping Complex, Second Floor

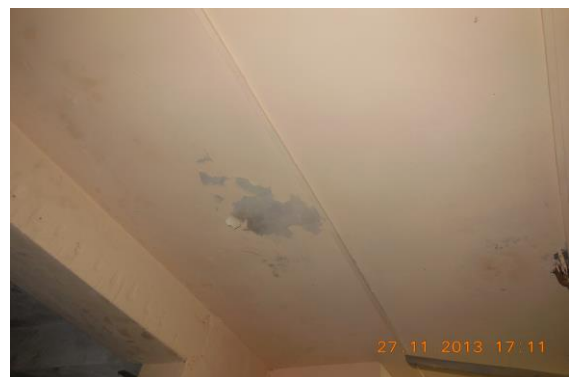
Photo 94

Damaged Portion on Wall No. 2 of Hall No. 1 of Munshi Shopping Complex, Second Floor

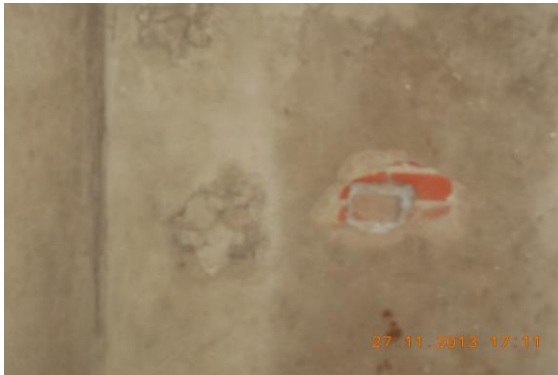
Photo 96

Damaged Portion on Wall No. 4 of Shaft of Munshi Shopping Complex, Second Floor

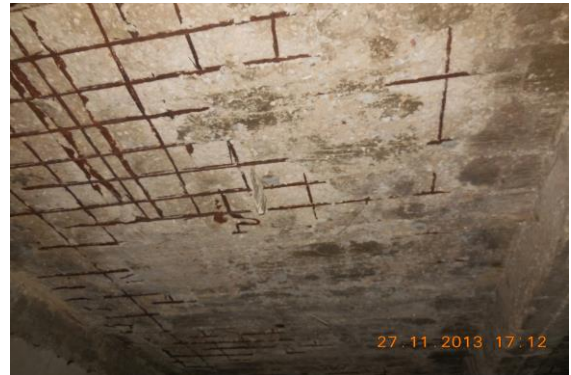
Photo 97

Peeling of Plaster on Roof of Hall No. 2 of Munshi Shopping Complex, Second Floor

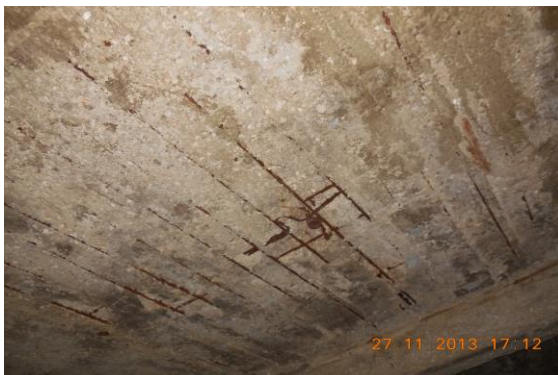
Photo 98

Peeling of Plaster on Roof of Hall No. 2 of Munshi Shopping Complex, Second Floor

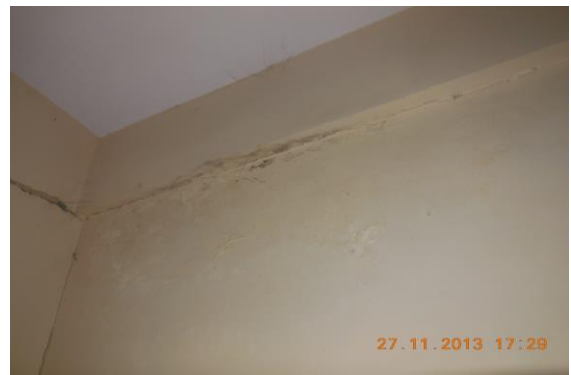
Photo 99

Dampness/Seepage on Wall No. 4 of Toilet No. 1 of Munshi Shopping Complex, Second Floor

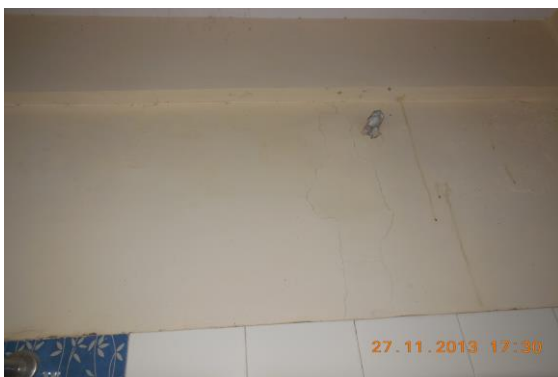
Photo 100

Plaster Crack on Wall No. 4 of Toilet No. 1 of Munshi Shopping Complex, Second Floor

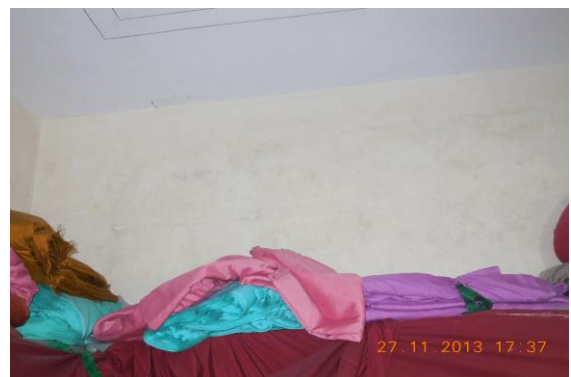
Photo 101

Dampness/Seepage on Wall No. 3 of Hall No. 1 of Munshi Shopping Complex, Second Floor

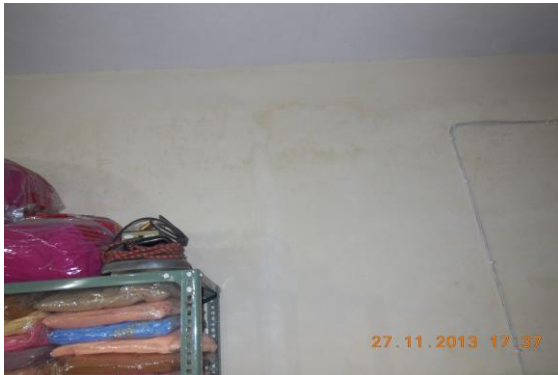
Photo 102

Dampness/Seepage on Wall No. 1 of Hall No. 1 of Munshi Shopping Complex, Second Floor

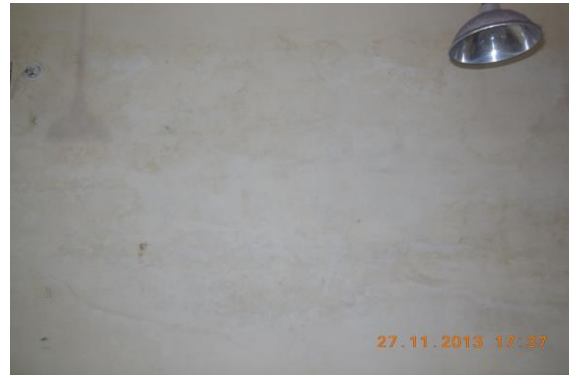
Photo 103

Dampness/Seepage on Wall No. 4 of Hall No. 1 of Munshi Shopping Complex, Second Floor

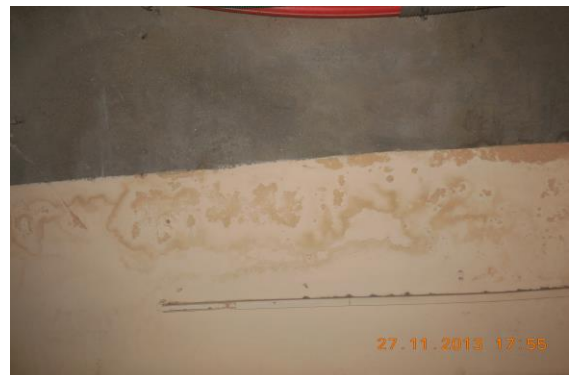
Photo 105

Dampness/Seepage on Wall No. 4 of Stair 1 SF to Third Floor of Munshi Shopping Complex, Third Floor

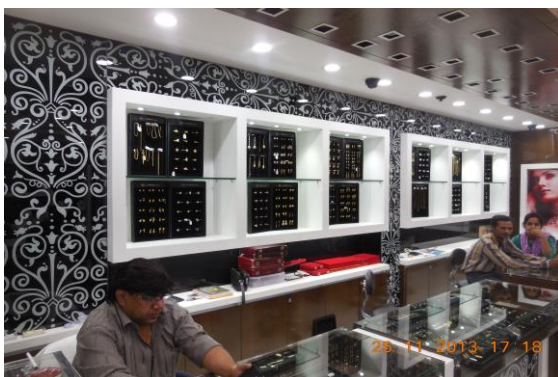
Photo 106

Wall No. 1 of Shop No.337 & 338 of Ground Floor Covered With Wooden work

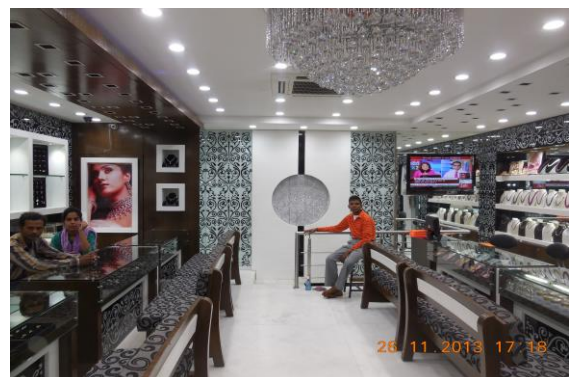
Photo 107

Wall No. 4 of Shop No.337 & 338 of Ground Floor Covered With Wooden work

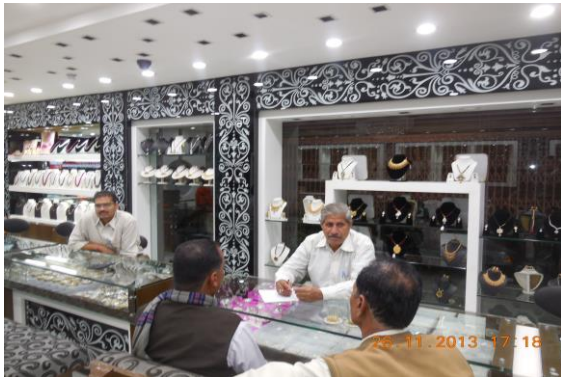
Photo 108

Wall No. 2 of Shop No.337 & 338 of Ground Floor Covered With Wooden work

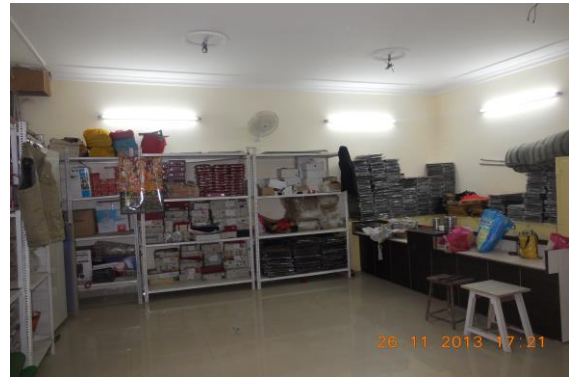
Photo 109

Wall No. 4 of Shop No.337 & 338 of Basement Covered With Material

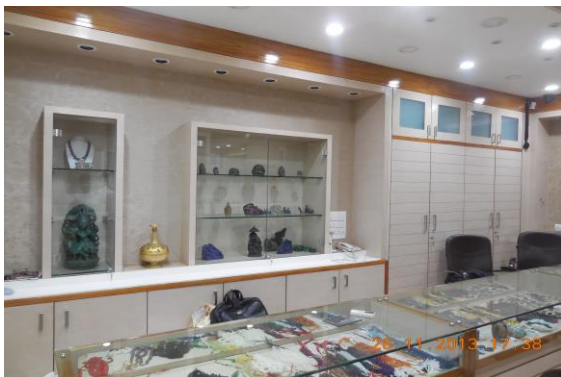
Photo 110

Wall No. 1 of Shop No.335, Ground Floor Covered With Wooden Racks

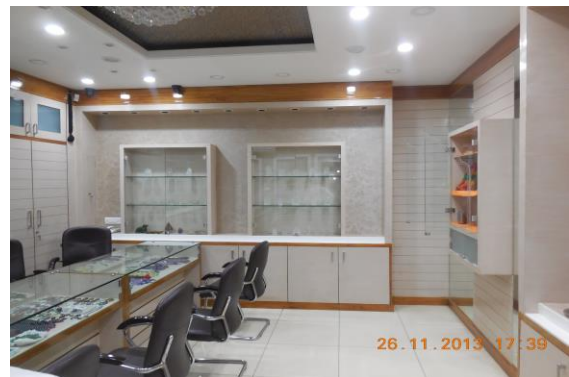
Photo 111

Wall No. 4 of Shop No.335, Ground Floor Covered With Wooden Racks

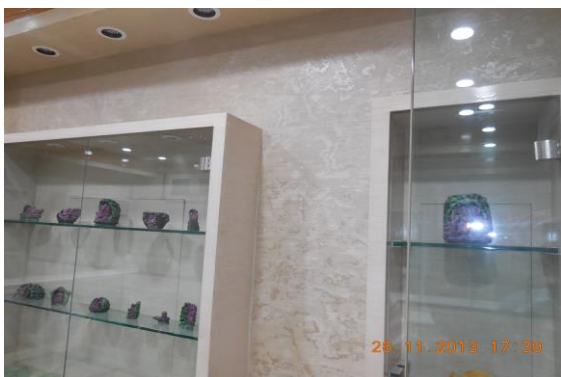
Photo 112

Wall No. 2 of Shop No.335, Ground Floor Covered With Wooden Racks

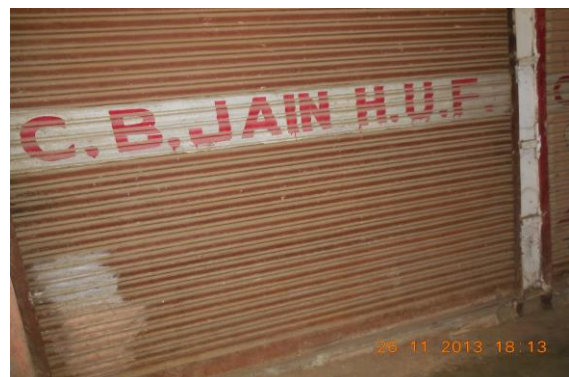
Photo 113

Shop No.17 of Basement Locked

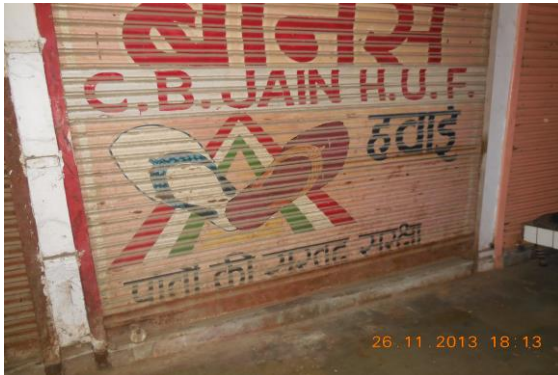
Photo 114  
Shop No.18 of Basement Locked

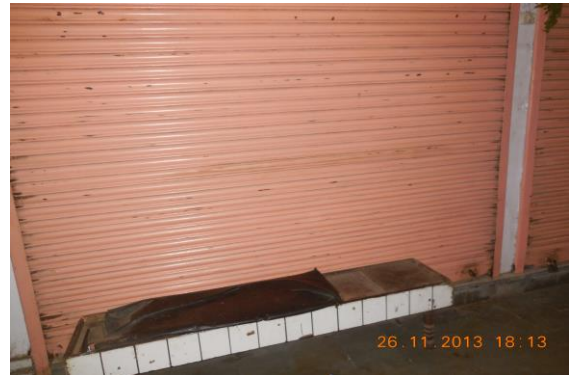
Photo 115  
Shop No.19 of Basement Locked

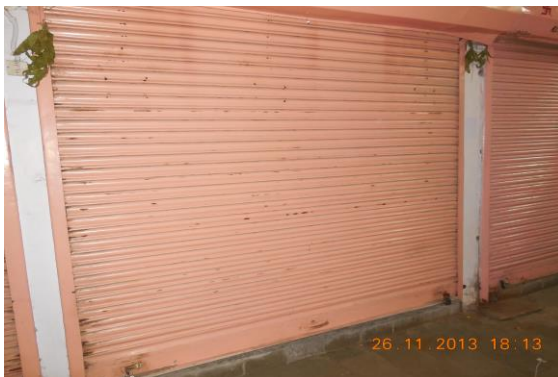
Photo 116  
Shop No.20 of Basement Locked

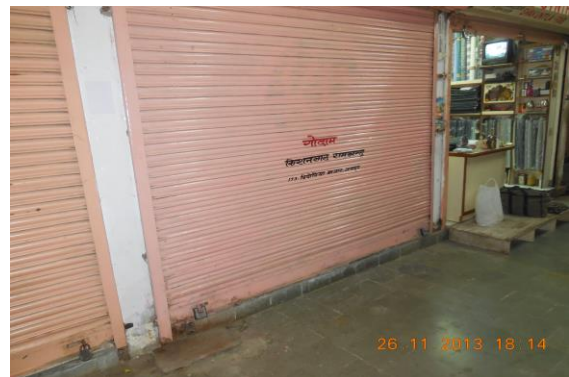
Photo 117  
Shop No.21 of Basement Locked

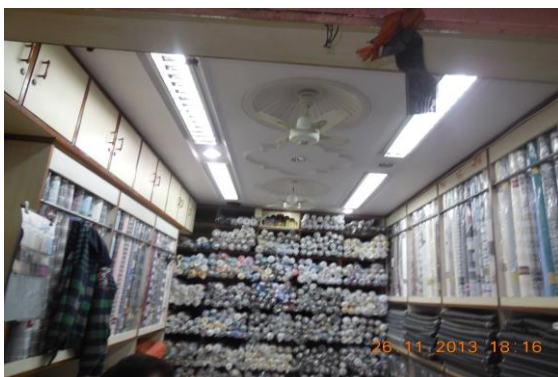
Photo 118  
Wall No. 1, 2 & 4 of Shop No.22 of Basement Covered With Wooden Racks & Material & Falls Ceiling

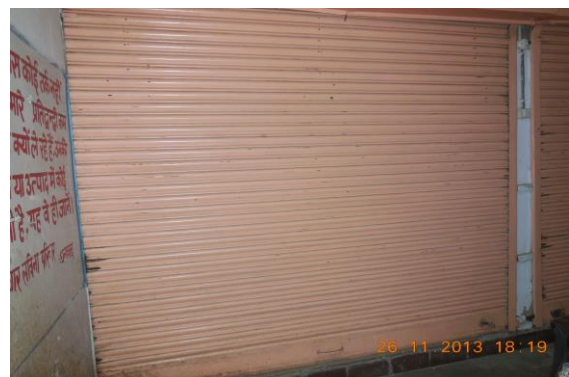
Photo 119  
Shop No.23 of Basement Locked

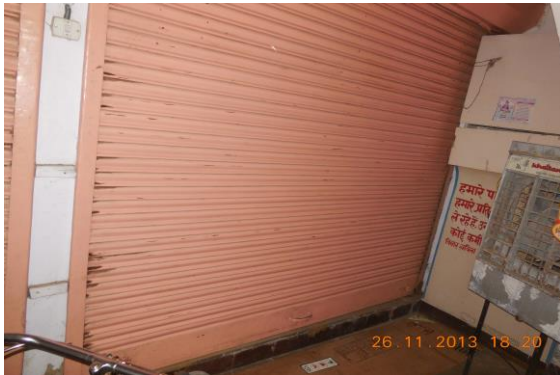
Photo 120  
Shop No.24 of Basement Locked

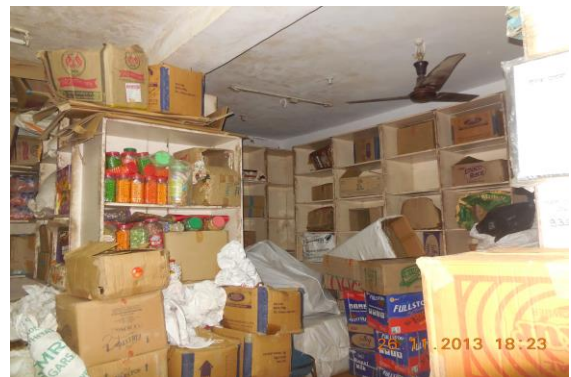
Photo 123  
Wall No. 1 & 4 of Shop No.27 of Basement Covered With Wooden Works & Material

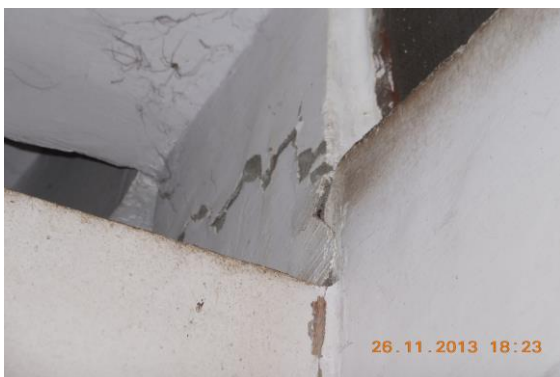
Photo 124  
Wall No. 2 & 4 of Shop No.27 of Basement Covered With Wooden Works & Material

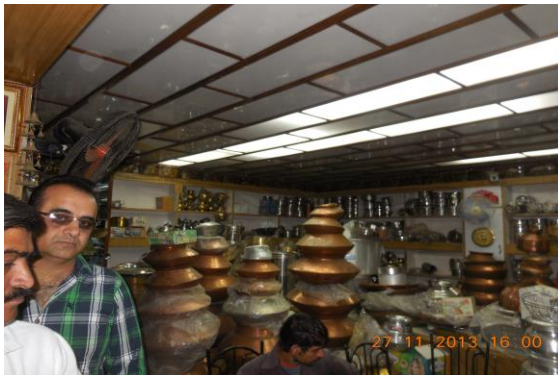
Photo 128  
Wall No. 1, 4 & Roof of Shop No. 1 & 2 of Munshi Shopping Complex,  
Ground Floor Covered With Material & Falls Ceiling

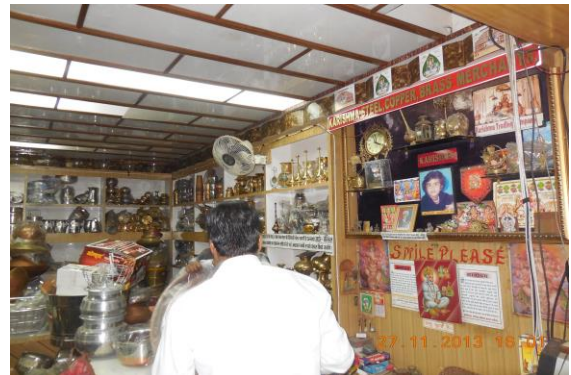
Photo 129  
Wall No. 2 of Shop No. 1 & 2 of Munshi Shopping Complex, Ground  
Floor Covered With Material

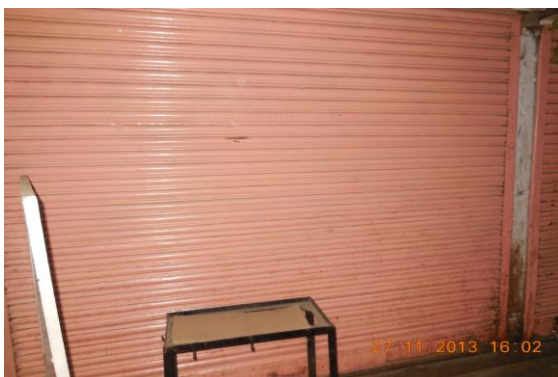
Photo 130  
Shop No. 3 of Munshi Shopping Complex, Ground Floor Locked

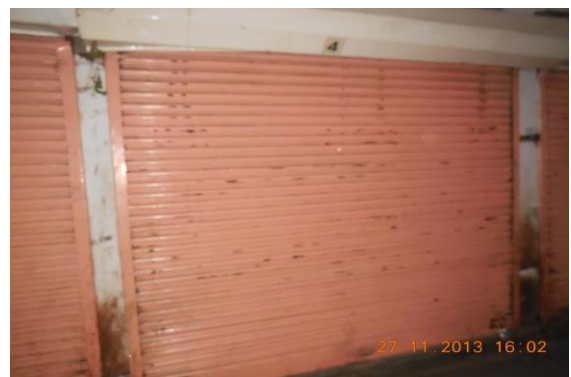
Photo 131  
Shop No. 4 of Munshi Shopping Complex, Ground Floor Locked

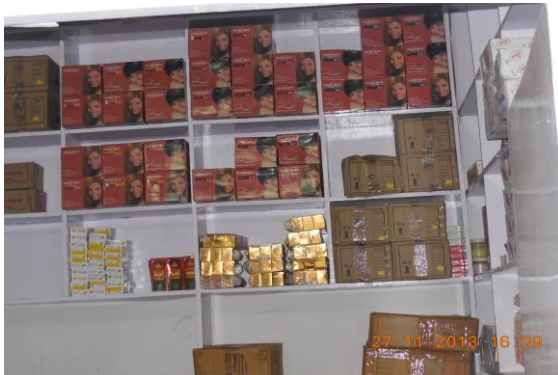
Photo 132

Wall No. 4 of Shop No. 13 of Munshi Shopping Complex, Ground Floor Covered with Material

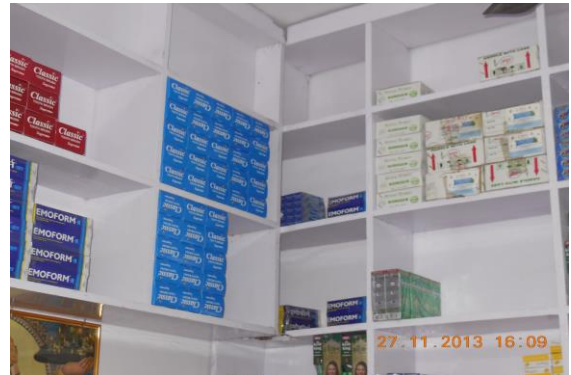
Photo 133

Wall No. 1 & 4 of Shop No. 13 of Munshi Shopping Complex, Ground Floor Covered with Material

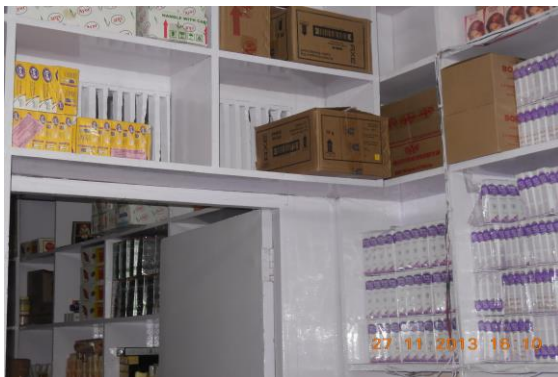
Photo 134

Wall No. 2 of Shop No. 13 of Munshi Shopping Complex, Ground Floor Covered with Material

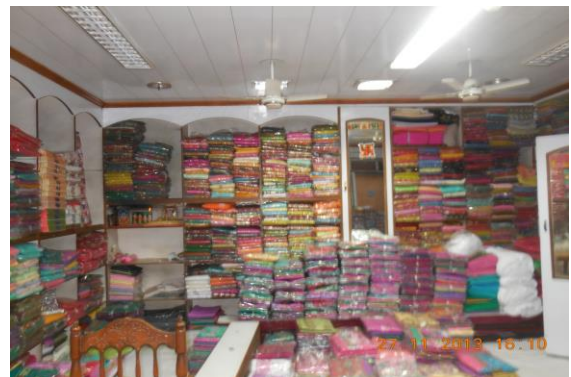
Photo 135

Wall No. 4 of Shop No. 10 & 11 of Munshi Shopping Complex, Ground Floor Covered with Material

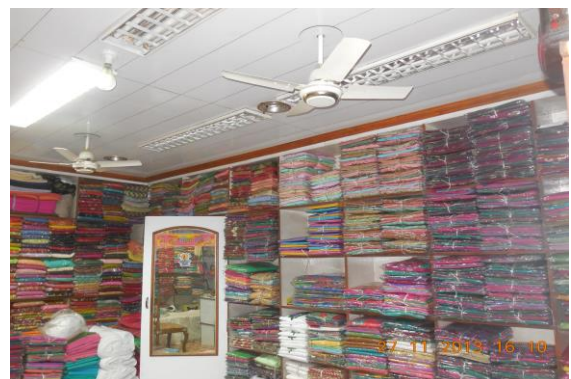
Photo 136

Wall No. 1 of Shop No. 10 & 11 of Munshi Shopping Complex, Ground Floor Covered with Material

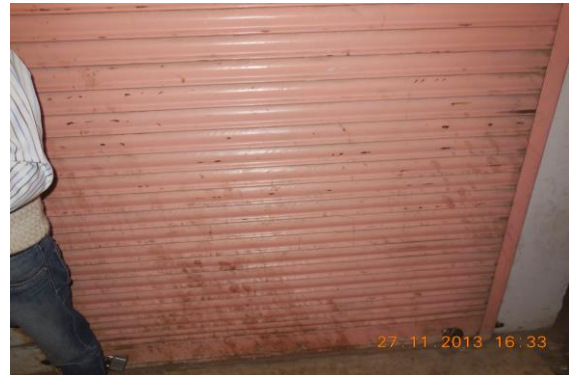
Photo 138

Bank of Baroda of Munshi Shopping Complex, First Floor Locked

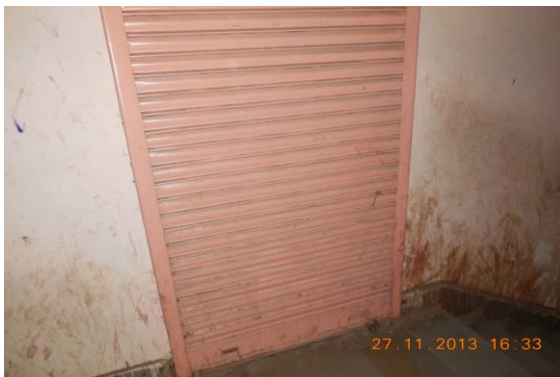
Photo 139

Shop No. 4 & 5 of Munshi Shopping Complex, First Floor Locked

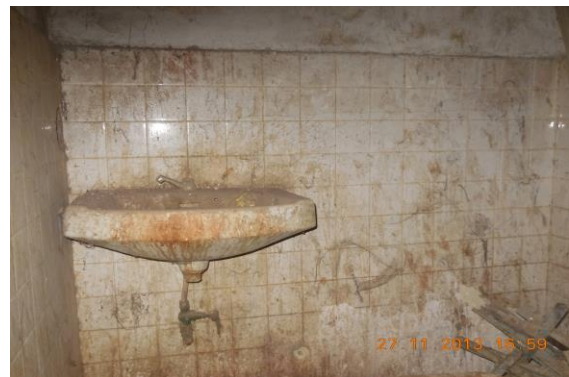
Photo 140

Shop No. 4 & 5 of Munshi Shopping Complex, First Floor Locked

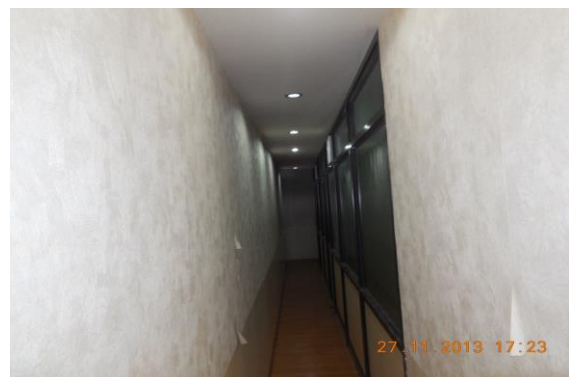
Photo 142

All Wall of Sonia Creation of Munshi Shopping Complex, Second Floor Covered With Wooden & Material

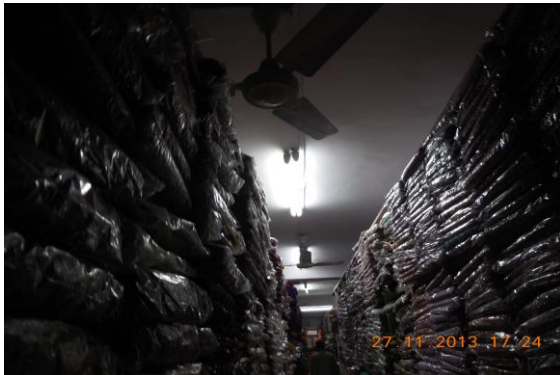
Photo 143

All Wall of Sonia Creation of Munshi Shopping Complex, Second Floor Covered With Wooden & Material
