### Pre Building Condition Survey Report

Name and Address of Structure :	Badi Chopar to Ramp Area (UP Line)
---------------------------------	------------------------------------

Name of the Project	<b>Contract JMRC-UG1B</b> “Design and Construction of Tunnel between Chandpole and Badi Chouper and reverse line by Shield TBM, Underground Metro Stations at Choti Chouper and Badi Chouper by Cut and Cover Methods on East West Corridor of Jaipur Metro Rail Corporation Limited .”	
Owner :

Pre Building Condition Survey Report Badi Chopar to Ramp Area (UP Line)

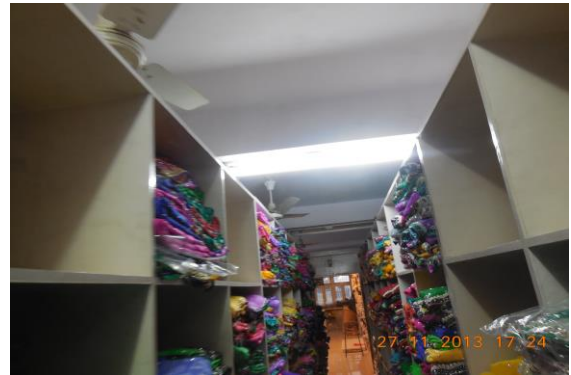
Photo 144

All Wall of Sonia Creation of Munshi Shopping Complex, Second Floor Covered With Wooden & Material

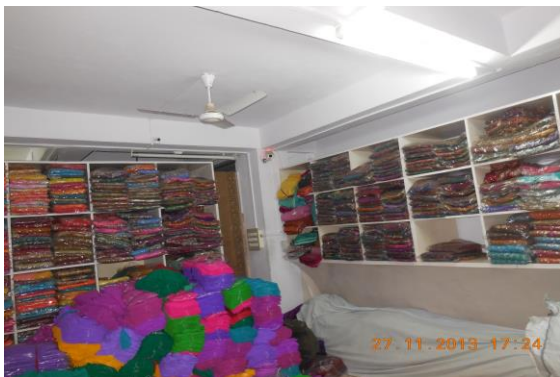
Photo 145

All Wall of Sonia Creation of Munshi Shopping Complex, Second Floor Covered With Wooden & Material

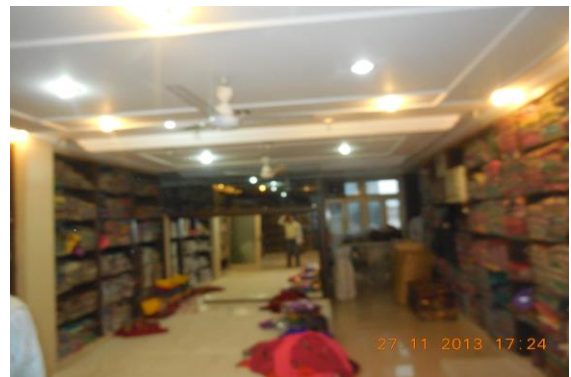
Photo 146

Wall No. All Wall of Sonia Creation of Munshi Shopping Complex, Second Floor Covered With Wooden & Material

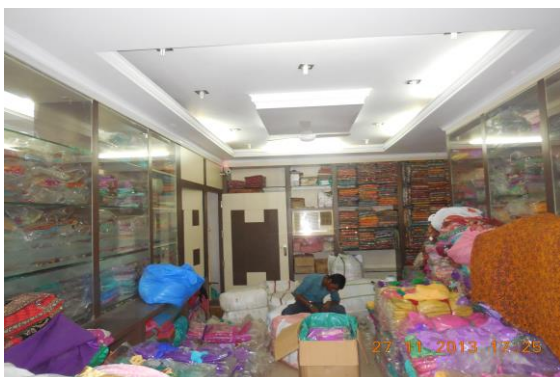
Photo 147

Wall No. All Wall of Sonia Creation of Munshi Shopping Complex, Second Floor Covered With Wooden & Material

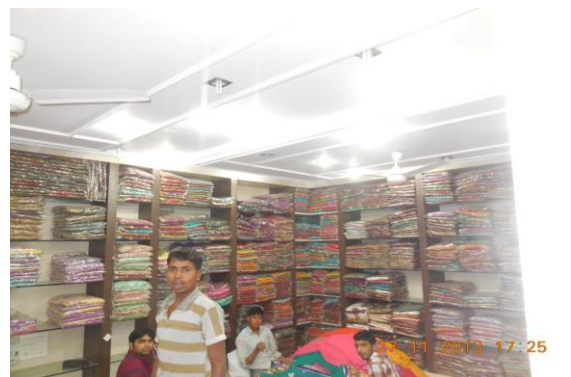
Photo 148

All Wall of Sonia Creation of Munshi Shopping Complex, Second Floor Covered With Wooden & Material

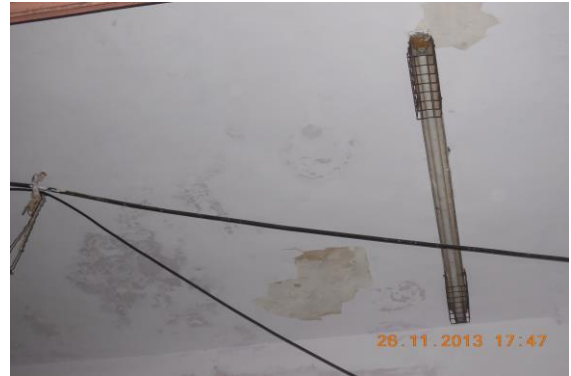
Photo 2  
Dampness/Seepage on Roof of Varanda of Shop No.335 of Ground Floor

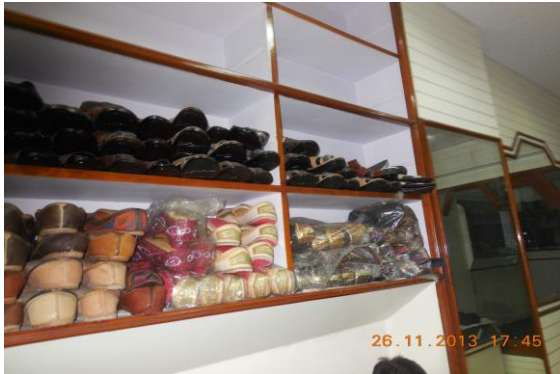
Summary of Areas that Could not be Surveyed			
Serial No.	Location	Description	Photo No.
1	Wall No. 1 Part A of Shop no.335 Ground Floor	Covered With Material	3
2	Wall No. 2 Part A of Shop no.335 Ground Floor	Covered With Material	4
3	Roof Part B of Shop no.335 Ground Floor	Covered with False Ceiling	5

Photo 3  
Wall No. 1 of Part A of Shop no.335 of Ground Floor Covered With Material

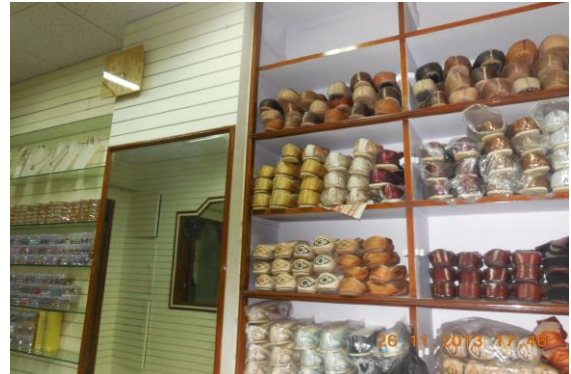
Photo 4  
Wall No. 2 of Part A of Shop no.335 of Ground Floor Covered With Material

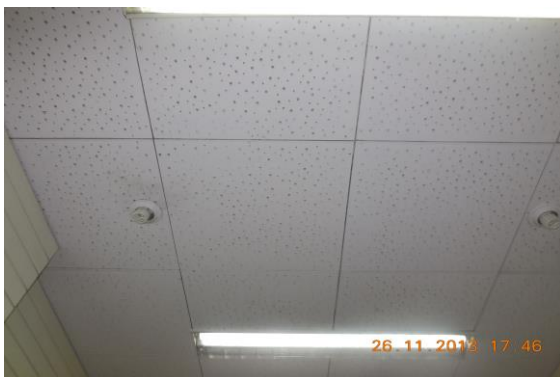
Photo 5  
Roof of Part B of Shop no.335 of Ground Floor Covered with False Ceiling

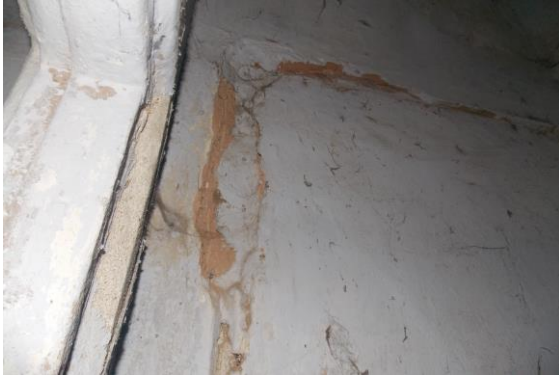
Photo 13

Inclined Crack on Wall No. 1 of Bathroom No. , Ground Floor, Approx. Width = 0.7mm, Approx. Length = 2m. , Height from Floor = m.

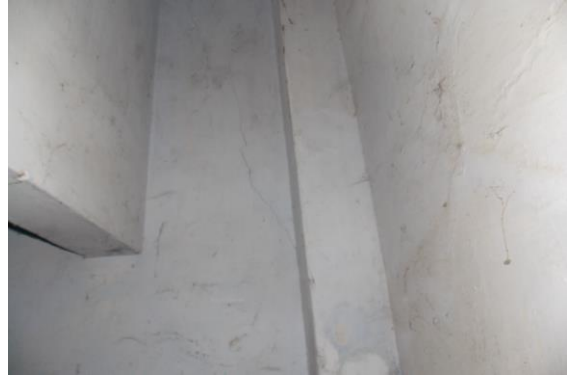
Photo 14

Inclined Crack on Wall No. 4 of Passage No.1, Ground Floor, Approx. Width = 0.3mm, Approx. Length = 1m. , Height from Floor = m.

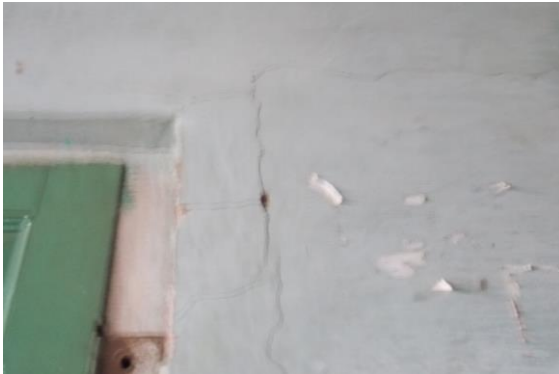
Photo 15

Inclined Crack on Wall No. 3 of Garrage, Ground Floor, Approx. Width = 0.6mm, Approx. Length = 1.3m. Distance from Wall no.2 = 2.8m, Height from Floor = 1.8m.

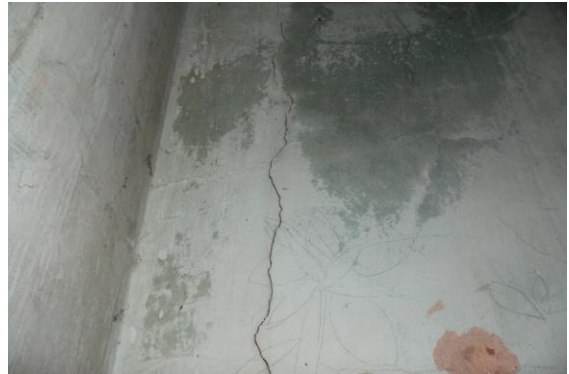
Photo 16

Inclined Crack on Wall No. 3 of Garrage, Ground Floor, Approx. Width = 1mm, Approx. Length = 1.2m. Distance from Wall no.2 = 3.8m, Height from Floor = 1.1m.

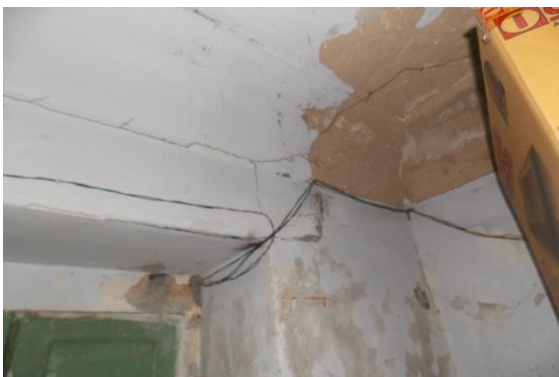
Photo 17

Inclined Crack on Wall No. 4 & Roof of Room No. 2, Ground Floor, Approx. Width = 2mm, Approx. Length = 2m. , Height from Floor = m.

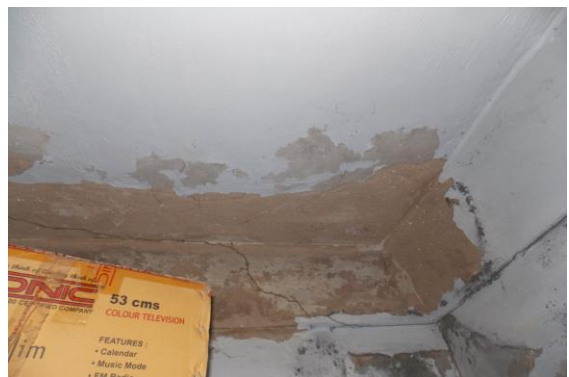
Photo 18

Inclined Crack on Wall No. 2 & Roof of Room No. 2, Ground Floor, Approx. Width = 2mm, Approx. Length = 2m. , Height from Floor = m.

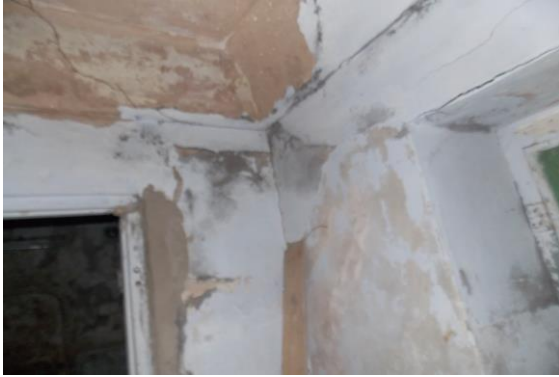
Photo 19

Inclined Crack on Wall No. 2 & 3 of Room No. 2, Ground Floor, Approx.  
Width = 2mm, Approx. Length = 2m.  
, Height from Floor = m.

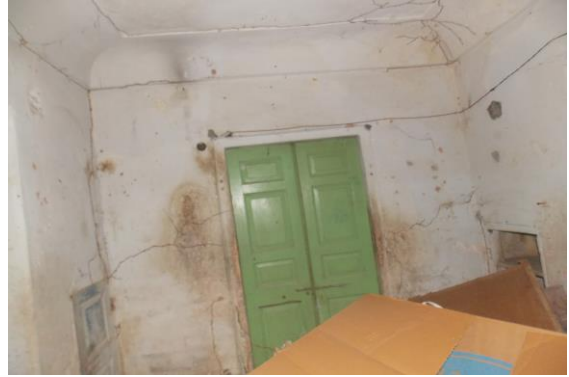
Photo 20

Inclined Crack on Wall No. 1 of Room No. 2, Ground Floor, Approx.  
Width = 2mm, Approx. Length = 1m.  
, Height from Floor = m.

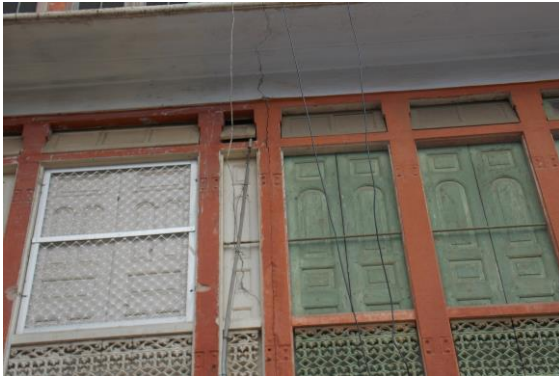
Photo 21

Inclined Crack on Shade of Open sky No.1, Ground Floor, Approx.  
Width = 2mm, Approx. Length = 5m.  
Distance from Left side wall No.1 = 4m, Height from Floor = 3m.

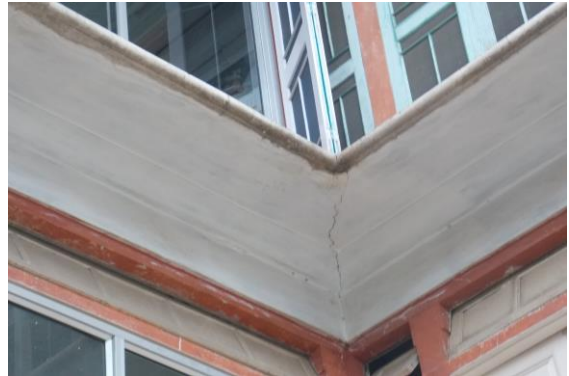
Photo 22

Inclined Crack on Shade of Open sky, First Floor, Approx. Width =  
1.5mm, Approx. Length = 1m.  
, Height from Floor = 7m.

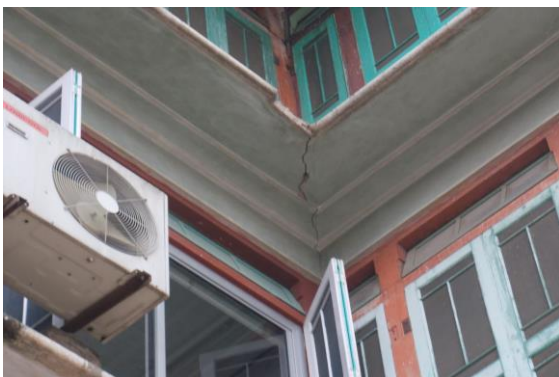
Photo 23

Inclined Crack on Sunshade of Open sky, Second Floor, Approx. Width  
= 2mm, Approx. Length = 1m.  
, Height from Floor = m.

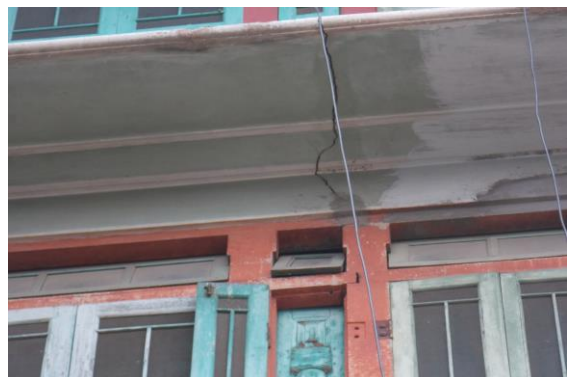
Photo 24

Inclined Crack on Sunshade of Open sky, Ground Floor, Approx. Width  
= 4mm, Approx. Length = 1m.  
Distance from Left side wall No.1 = 4m, Height from Floor = 0.1m.

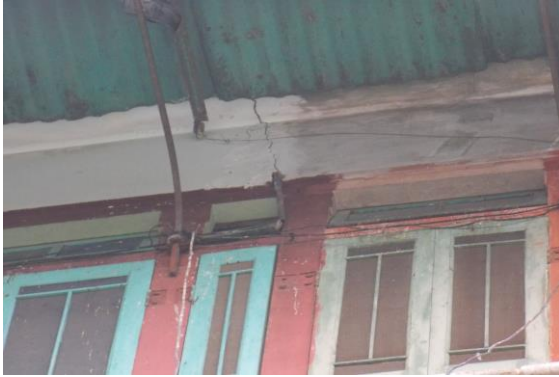
Photo 25

Inclined Crack on Frontside Wall of Building, Third Floor, Approx. Width = 4mm, Approx. Length = 1m.  
Distance from Left side wall No.1 = 4m, Height from Floor = 13m.

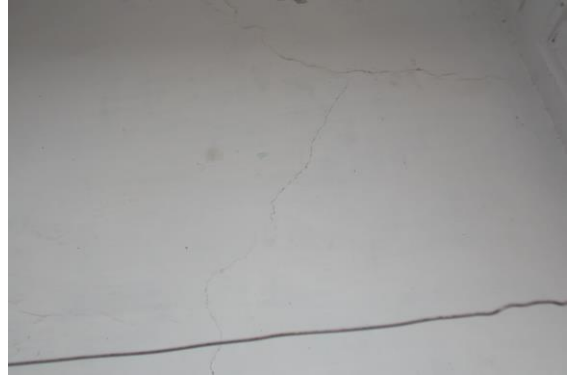
Photo 26

Inclined Crack on Frontside Wall of Building, Ground Floor, Approx. Width = 0.5mm, Approx. Length = 1m.  
, Height from Floor = m.

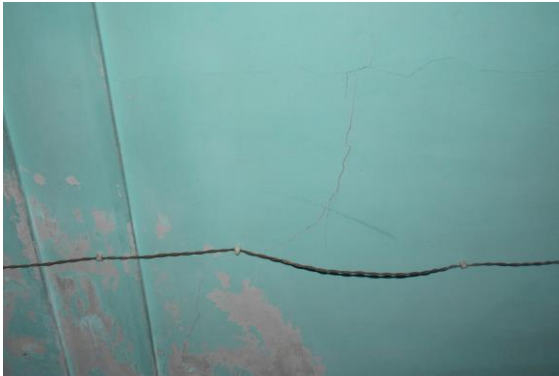
Photo 27

Inclined Crack on Roof of Room No. 2, Second Floor, Approx. Width = 0.5mm, Approx. Length = 1m.  
, Height from Floor = m.

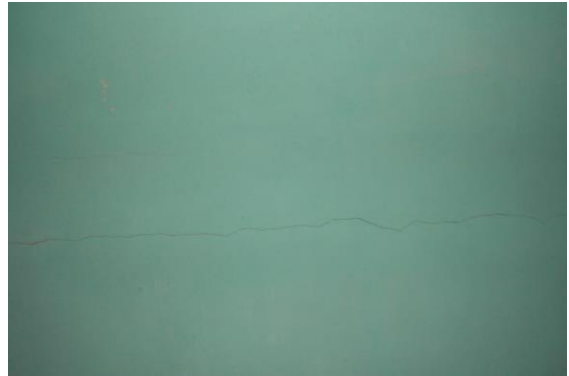
Photo 28

Horizontal Crack on Roof of Room No. 2, Second Floor, Approx. Width = 1mm, Approx. Length = 4m.  
Distance from Wall no.1 = 1.9m, Height from Floor = 2.7m.

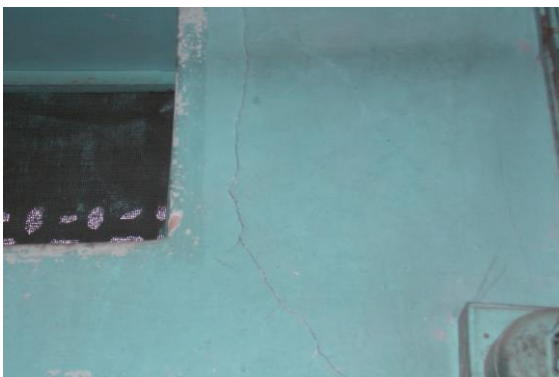
Photo 29

Inclined Crack on Wall No. 4 of Room No. 2, Second Floor, Approx. Width = 0.35mm, Approx. Length = 0.4m.  
Distance from Wall no.1 = 1.8m, Height from Floor = 2m.

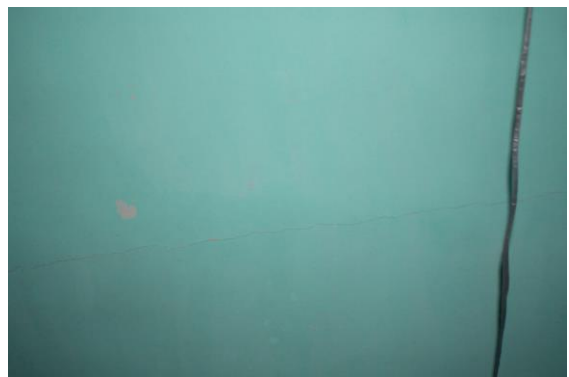
Photo 30

Inclined Crack on Roof of Room No. 2, Second Floor, Approx. Width = 0.5mm, Approx. Length = 1m.  
Distance from = m, Height from Floor = m.

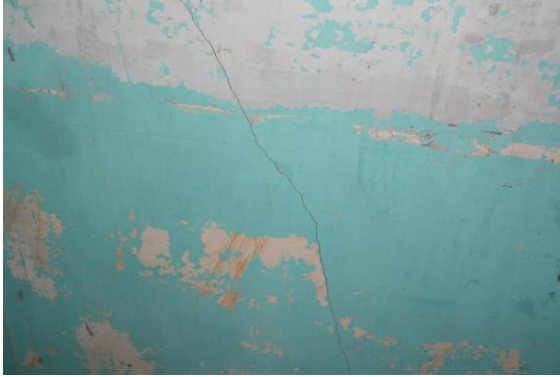
Photo 31

Inclined Crack on Wall No. 4 of Room No. 2, Second Floor, Approx. Width = 0.5mm, Approx. Length = 1.3m.  
Distance from Wall No.1 = 0.4m, Height from Floor = 0.1m.

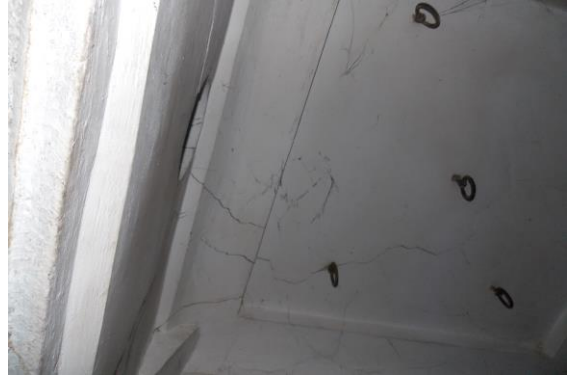
Photo 32

Inclined Crack on Roof of Store No.1, Second Floor, Approx. Width = 0.5mm, Approx. Length = 0.5m.  
Distance from = m, Height from Floor = m.

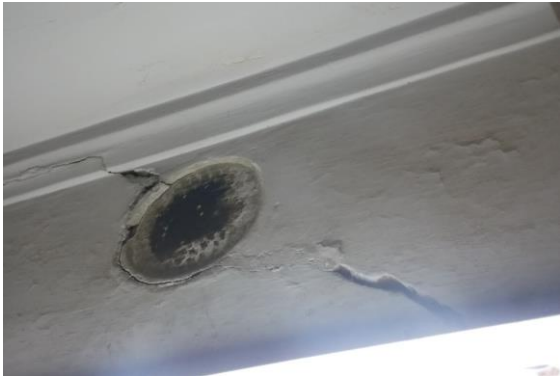
Photo 33

Inclined Crack on Wall No. 4 of Hall No. 1, Second Floor, Approx. Width = 15mm, Approx. Length = 1.8m.  
Distance from Wall No.2 = 1.8m, Height from Floor = 2.5m.

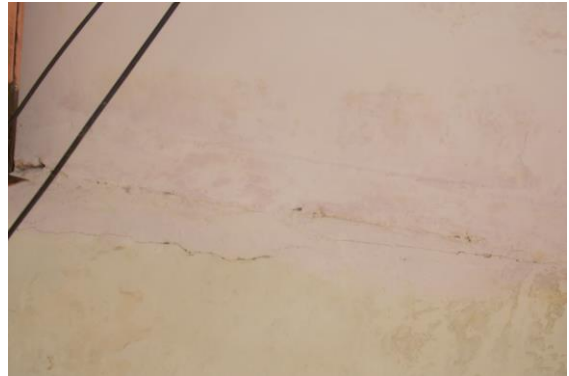
Photo 34

Horizontal Crack on Shop No. 332, Ground Floor, Approx. Width = 0.2mm, Approx. Length = 1.8m.  
Distance from Left External Col = 0m, Height from Floor = 3m.

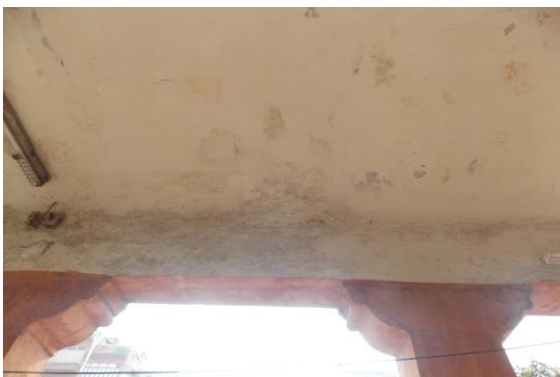
Photo 35

Horizontal Crack on Varandah Roof, Shop No. 332, Ground Floor, Approx. Width = 0.35mm, Approx. Length = 0.8m.  
Distance from Left External Col = 0m, Height from Floor = 3m.

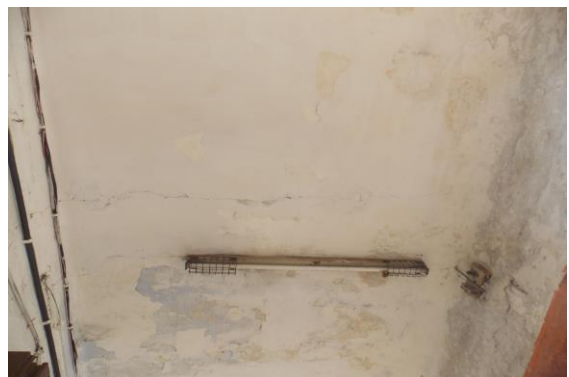
Photo 36

Horizontal Crack on Varandah Roof, Shop No. 332, Ground Floor, Approx. Width = 0.35mm, Approx. Length = 2m.  
Distance from Right External Col = 0m, Height from Floor = 3m.

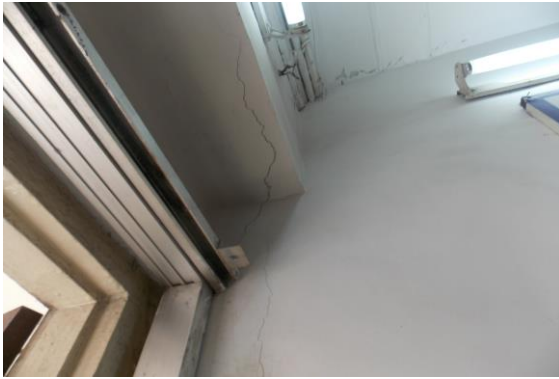
Photo 37

Inclined Crack on Wall No. 1 of Shop No. 334, Ground Floor, Approx.  
Width = 2mm, Approx. Length = 3m.  
, Height from Floor = 0m.

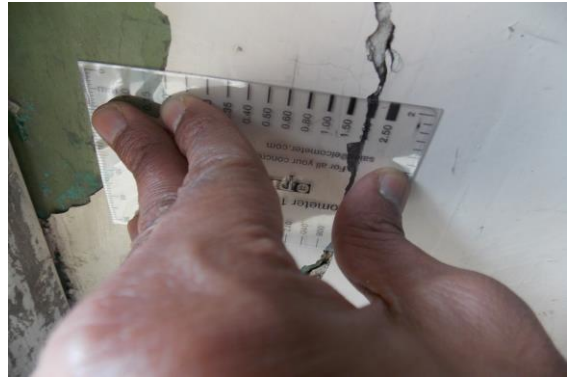
Photo 37A

Inclined Crack on Wall No. 1 of Shop No. 334, Ground Floor, Approx.  
Width = 2mm, Approx. Length = 3m.  
, Height from Floor = 0m.

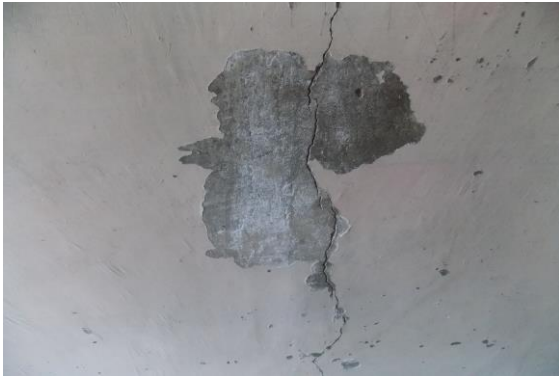
Photo 38

Inclined Crack on Wall No. 1 of Shop No. 334, Ground Floor, Approx.  
Width = 1mm, Approx. Length = 1m.  
Distance from Wall no. 3 = 1.5m, Height from Floor = 0m.

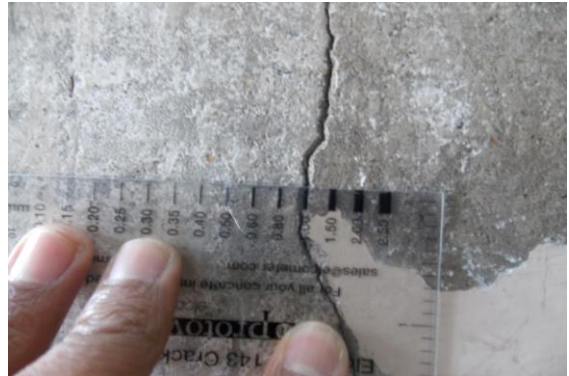
Photo 38A

Inclined Crack on Wall No. 1 of Shop No. 334, Ground Floor, Approx.  
Width = 1mm, Approx. Length = 1m.  
Distance from Wall no. 3 = 1.5m, Height from Floor = 0m.

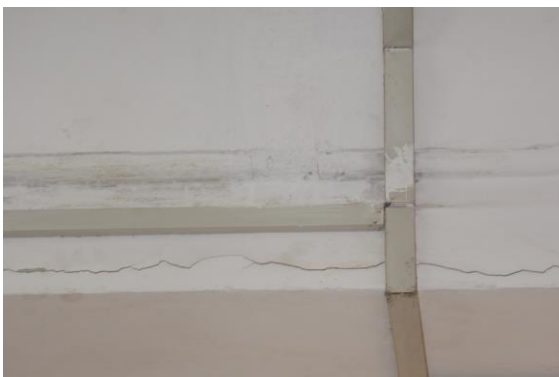
Photo 39

Horizontal Crack on Beam, Shop No. 334, Ground Floor, Approx. Width  
= 1.5mm, Approx. Length = 1.3m.  
Distance from Wall no.2 = 0.15m, Height from Floor = 3.1m.

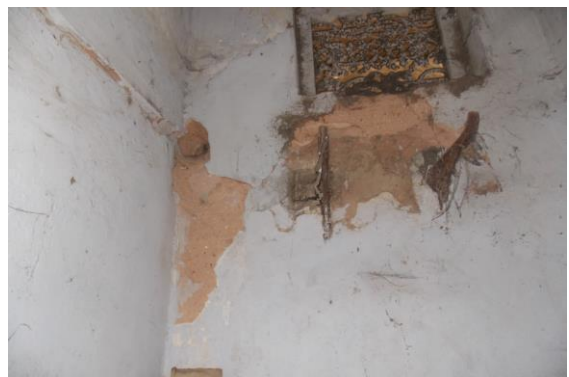
Photo 40

Peeling of Plaster on Wall No. 4 of Bathroom No. 1 of Ground Floor

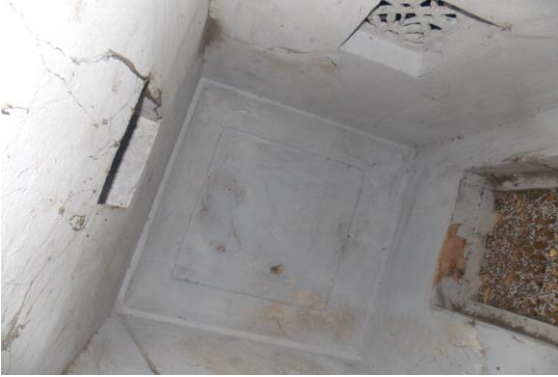
Photo 41  
Dampness/Seepage on Roof of Bathroom of Ground Floor

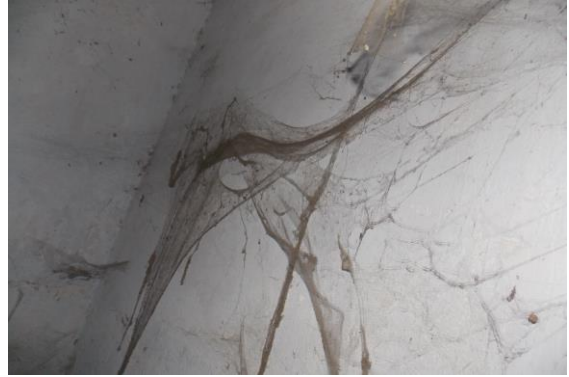
Photo 42  
Dampness/Seepage on Wall No. 2 of Bathroom No. 1 of Ground Floor

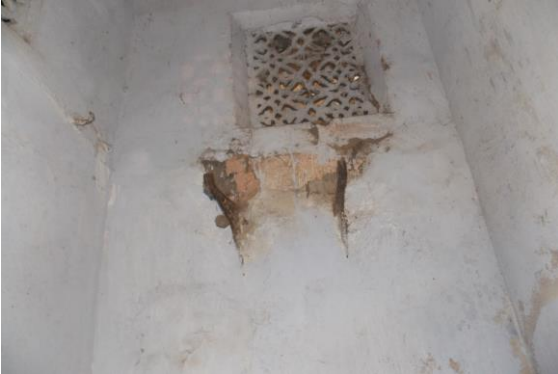
Photo 43  
Peeling of Plaster on Wall No. 4 of Toilet No. 1 of Ground Floor

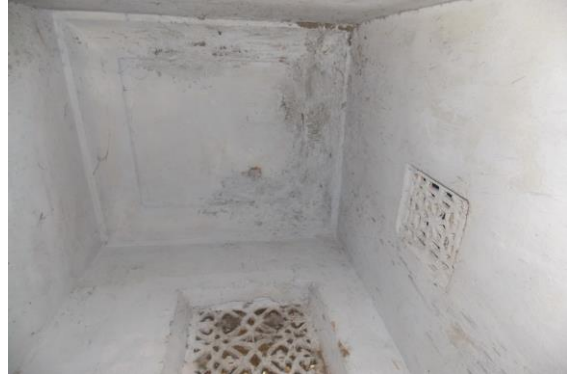
Photo 44  
Dampness/Seepage on Roof of Toilet No. 1 of Ground Floor

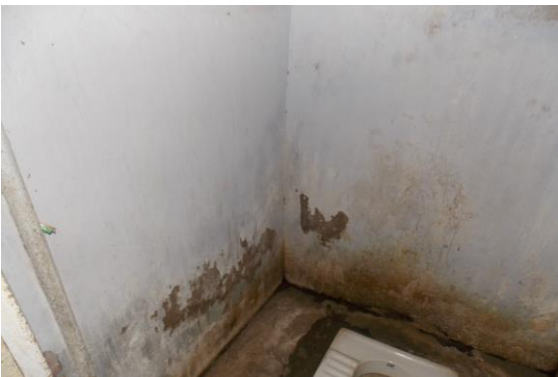
Photo 45  
Dampness/Seepage on Wall No. 1 & 4 of Toilet No. 1 of Ground Floor

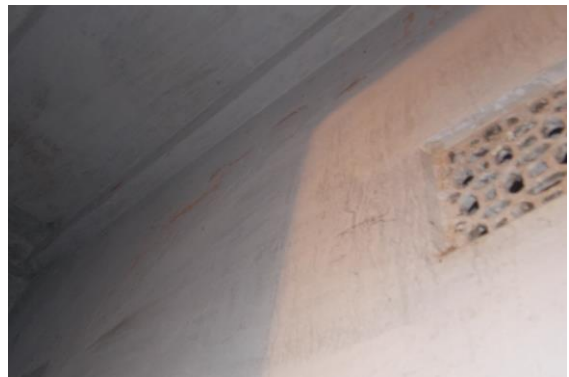
Photo 46  
Peeling of Plaster on Wall No. 2 of Passage No.2 of Ground Floor

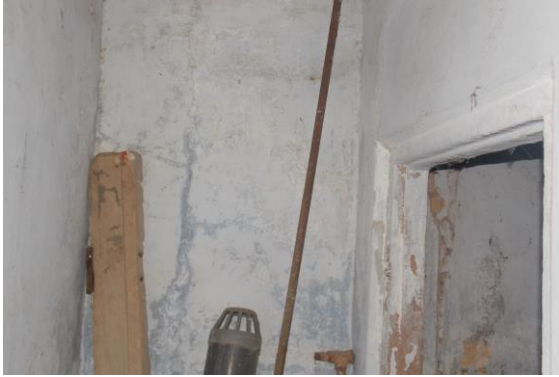
Photo 47

Dampness/Seepage on Wall No. 4 of Passage No.2 of Ground Floor

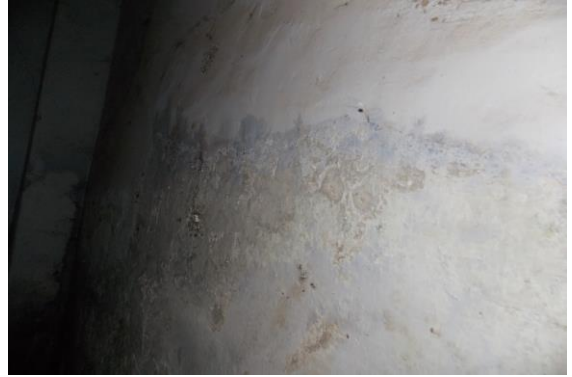
Photo 48

Dampness/Seepage on Wall No. 2 of Passage no.1 of Ground Floor

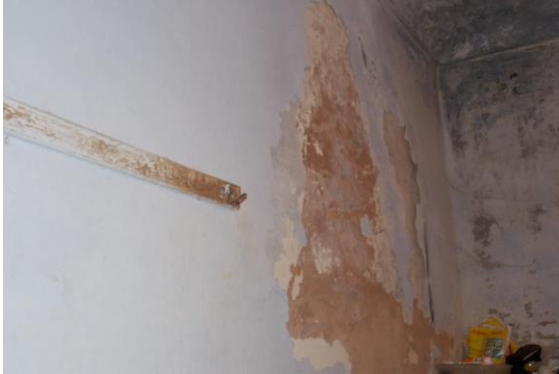
Photo 49

Peeling of Plaster on Wall No. 1 of Bathroom of Ground Floor

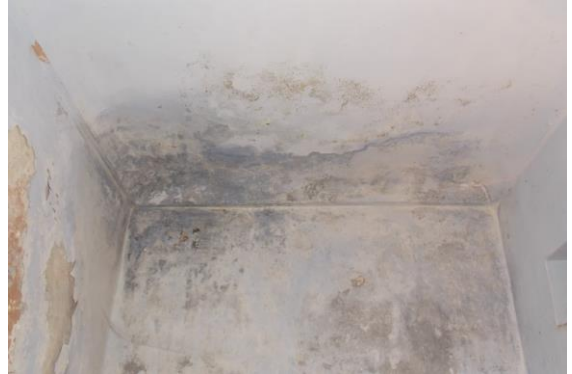
Photo 50

Dampness/Seepage on Wall No. 4 & Roof of Bathroom of Ground Floor

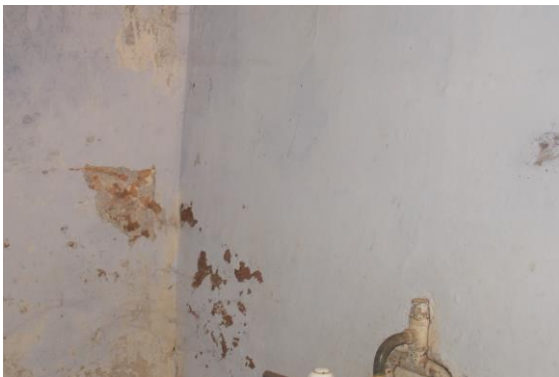
Photo 51

Peeling of Plaster on Wall No. 2 & 4 of Bathroom of Ground Floor

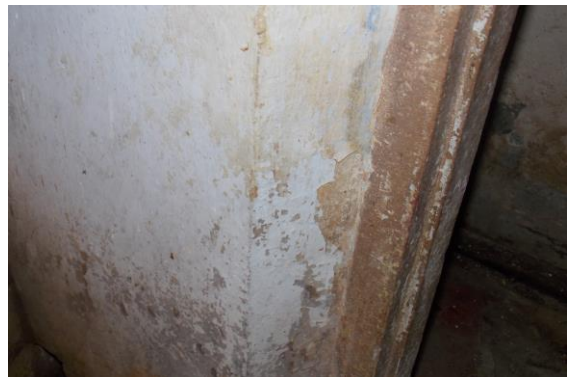
Photo 52

Dampness/Seepage on Wall No. 3 of Bathroom of Ground Floor

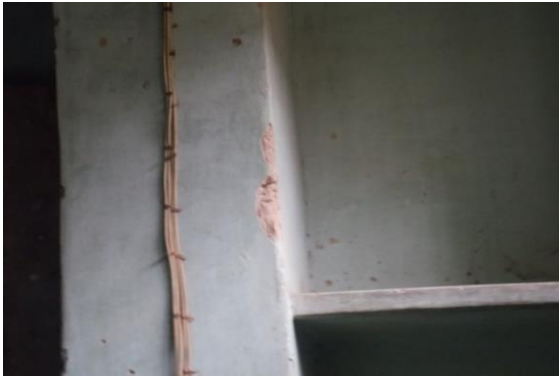
Photo 53

Damaged Portion on Wall No. 4 of Garrage of Ground Floor

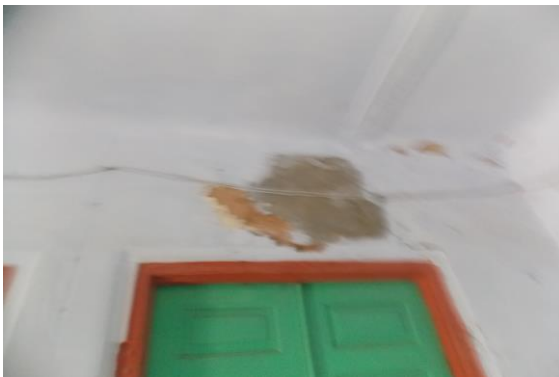
Photo 54

Dampness/Seepage on Wall No. 3 & Roof of Garrage of Ground Floor

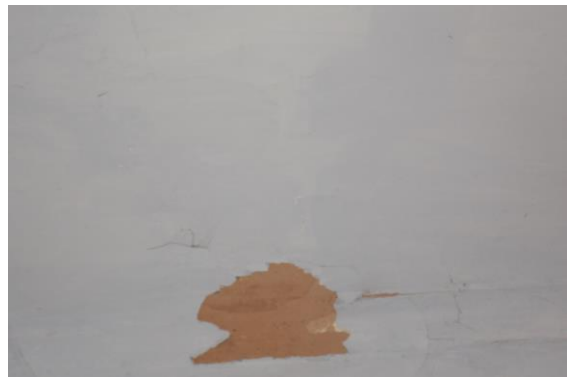
Photo 55

Peeling of Plaster on Wall No. 1 of open Area of Ground Floor

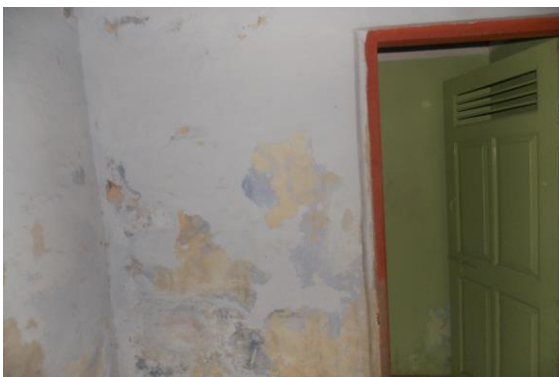
Photo 56

Peeling of Plaster on Roof of open Area of Ground Floor

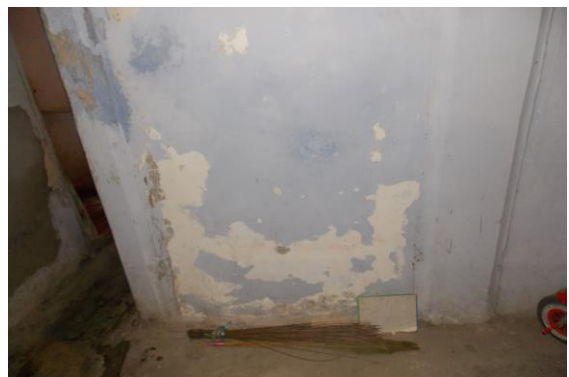
Photo 57

Peeling of Plaster on Wall No. 4 of open Area of Ground Floor

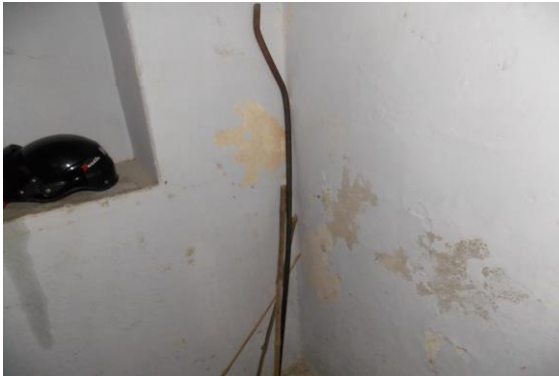
Photo 58

Peeling of Plaster on Wall No. 2 of open Area of Ground Floor

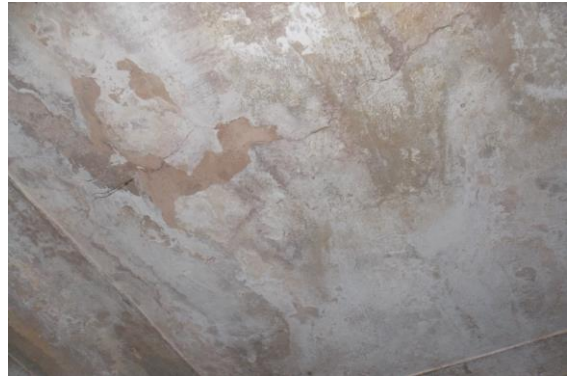
Photo 59

Peeling of Plaster on Wall No. 1 & 3 of open Area of Ground Floor

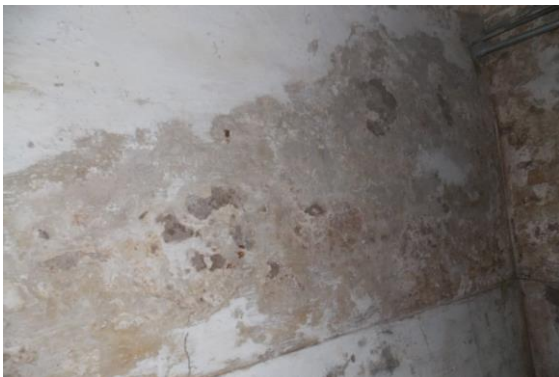
Photo 60

Dampness/Seepage on Roof of Room No. 3 of Ground Floor

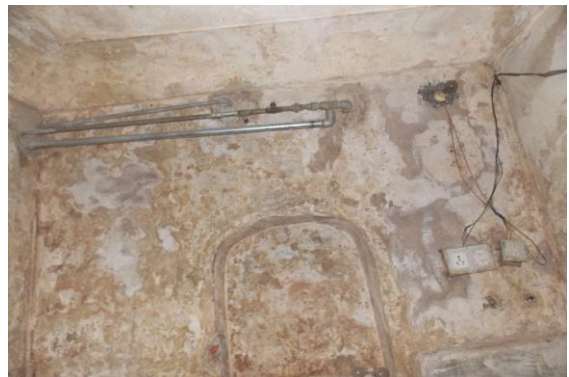
Photo 61

Dampness/Seepage on Wall No. 1 of Room No. 3 of Ground Floor

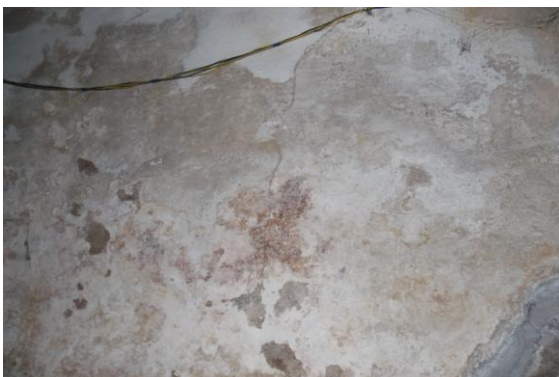
Photo 62

Dampness/Seepage on Wall No. 4 of Room No. 3 of Ground Floor

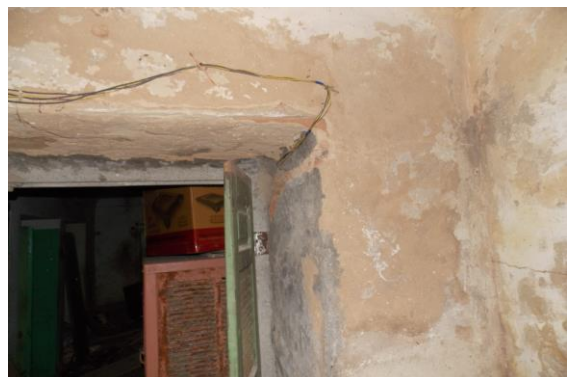
Photo 63

Dampness/Seepage on Wall No. 2 of Room No. 3 of Ground Floor

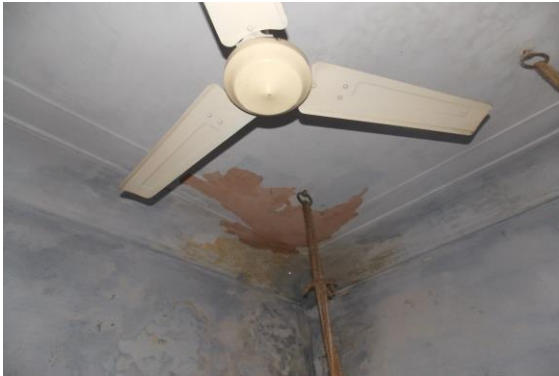
Photo 64

Dampness/Seepage on Wall No. 3 of Room No. 3 of Ground Floor

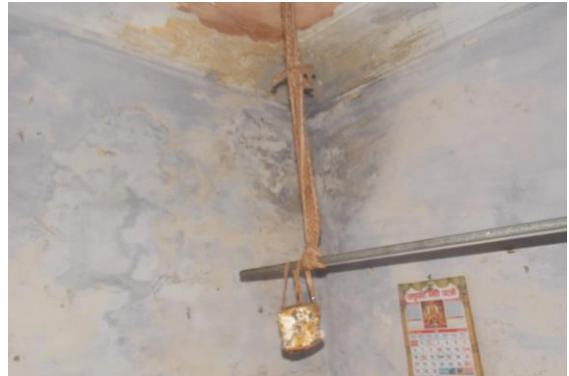
Photo 65

Peeling of Plaster on Roof of Room No. 1 of Ground Floor

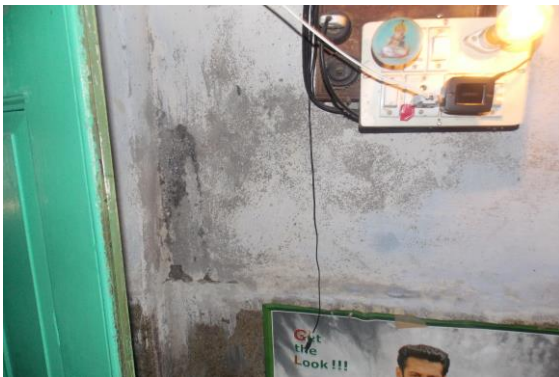
Photo 66

Dampness/Seepage on Wall No. 4 & 2 of Room No. 1 of Ground Floor

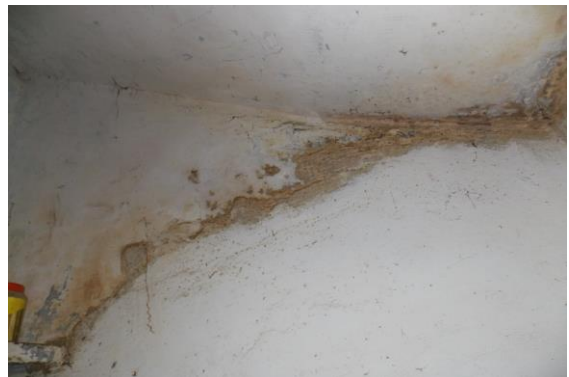
Photo 67

Dampness/Seepage on Wall No. 1 of Room No. 1 of Ground Floor

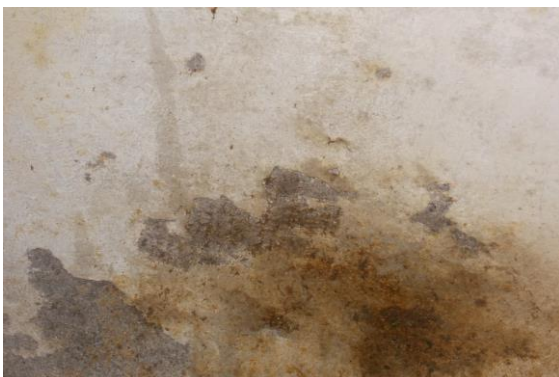
Photo 68

Dampness/Seepage on Wall No. 4 of Store no.1 of Ground Floor

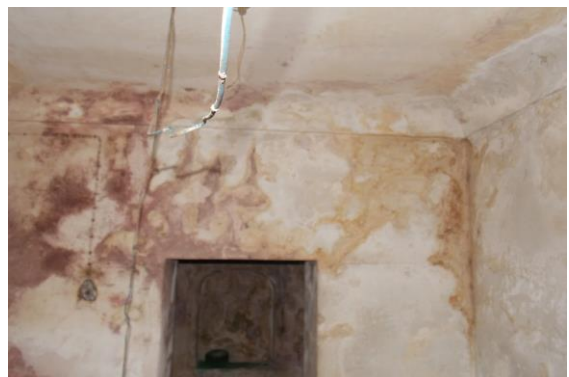
Photo 69

Dampness/Seepage on Wall No. 4 of Store no.1

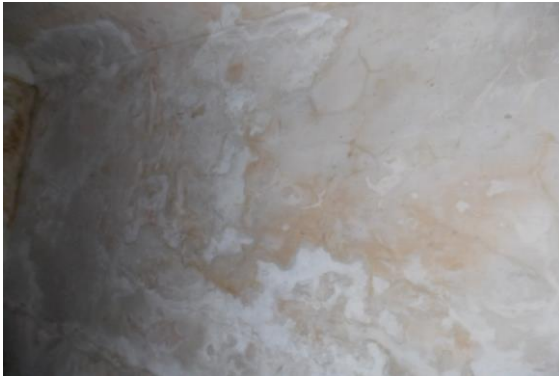
Photo 70

Dampness/Seepage on Wall No. 1, 4 & Roof of Hall No. 1 of Ground Floor

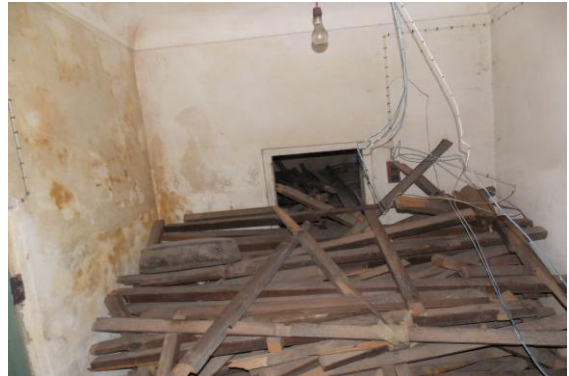
Photo 71

Dampness/Seepage on Wall No. 4 of Hall No. 1 of Ground Floor

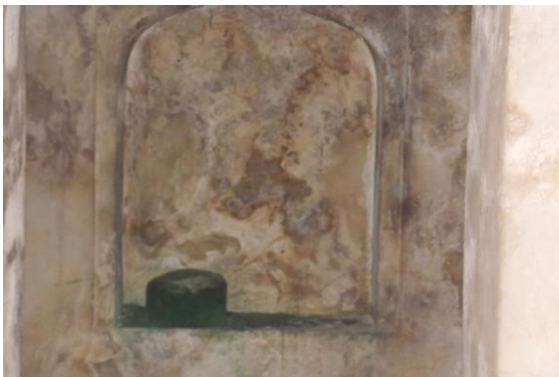
Photo 72

Dampness/Seepage on Wall No. 4 & Roof of Hall No. 1 of Ground Floor

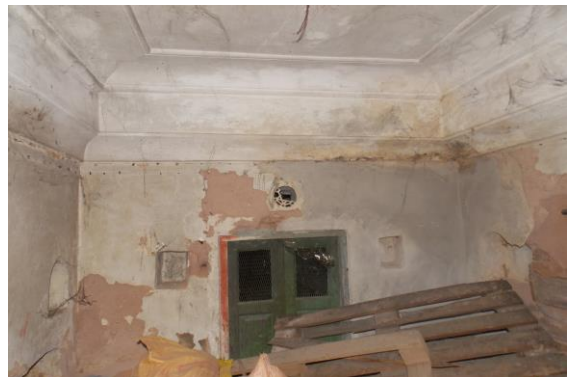
Photo 73

Dampness/Seepage on All Walls of Room No. 9 of Ground Floor

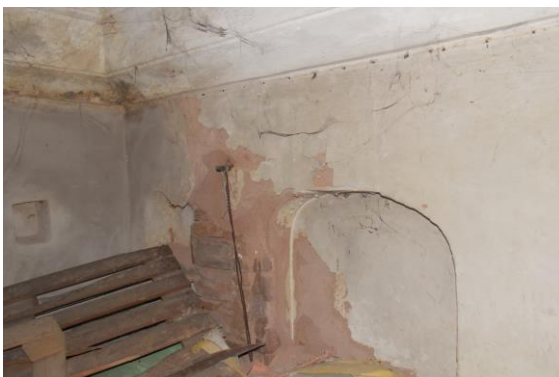
Photo 74

Damaged Portion on Wall No. 1 of Varanda No.3 of Ground Floor

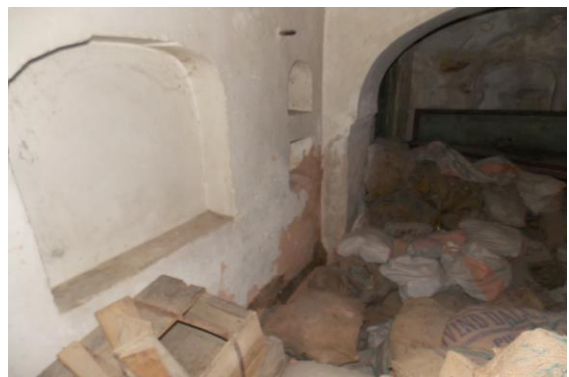
Photo 75

Damaged Portion on Wall No. 4 of Varanda No.3 of Ground Floor

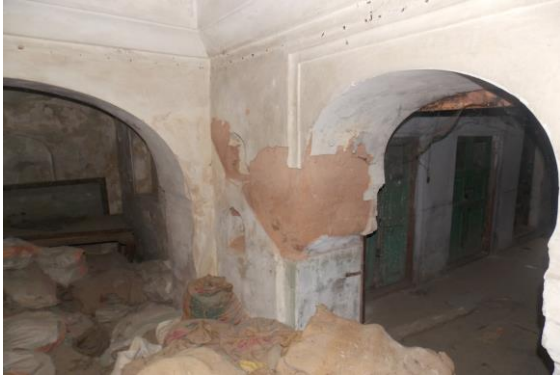
Photo 76

Damaged Portion on Wall No. 4 of Varanda No.3 of Ground Floor

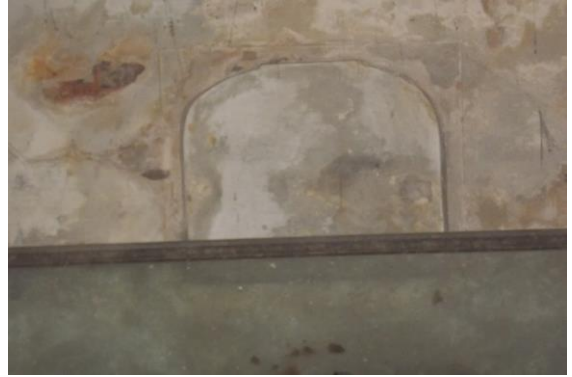
Photo 77

Damaged Portion on Wall No. 3 of Varanda No.3 of Ground Floor

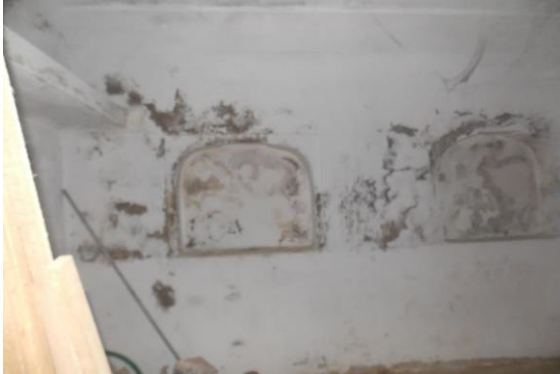
Photo 78

Damaged Portion on Wall No. 2 of Varanda No.3 of Ground Floor

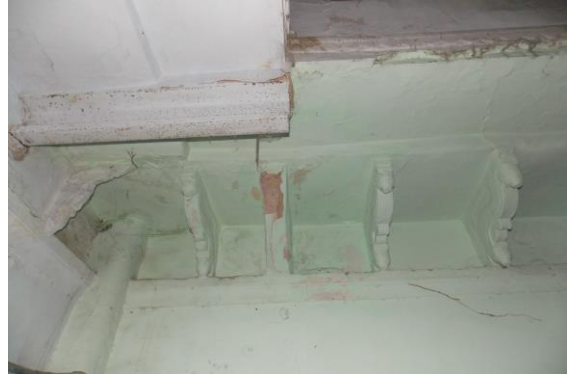
Photo 79

Peeling of Plaster on Wall No. 4 of Room No. 4 of Ground Floor

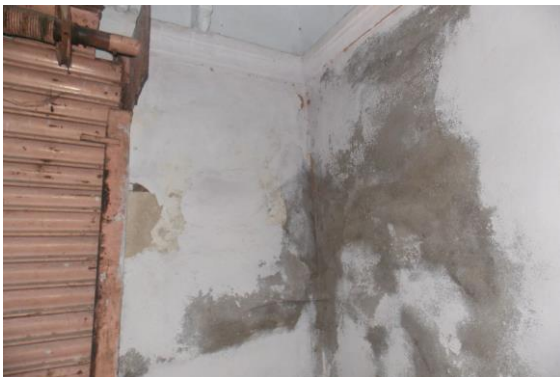
Photo 80

Peeling of Plaster on Wall No. 1 of Open sky No.2 of Ground Floor

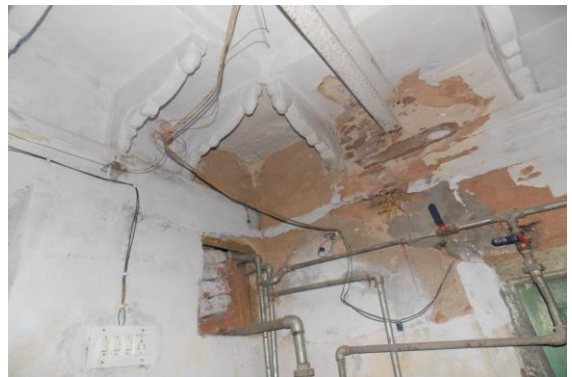
Photo 81

Dampness/Seepage on Wall No. 2 & 4 of Open sky No.2 of Ground Floor

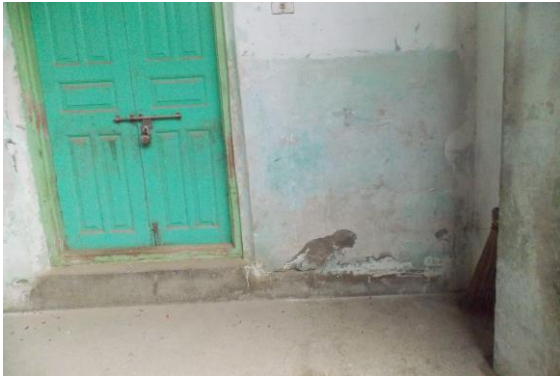
Photo 82

Damaged Portion on Wall No. 2, 3 & Roof of Open sky No.2 of Ground Floor

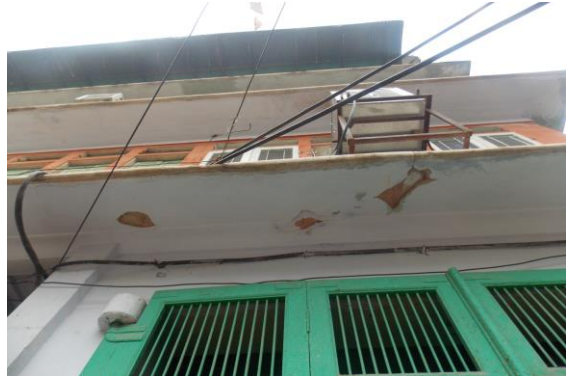
Photo 83

Peeling of Plaster on Frontside Wall of Building of Ground Floor

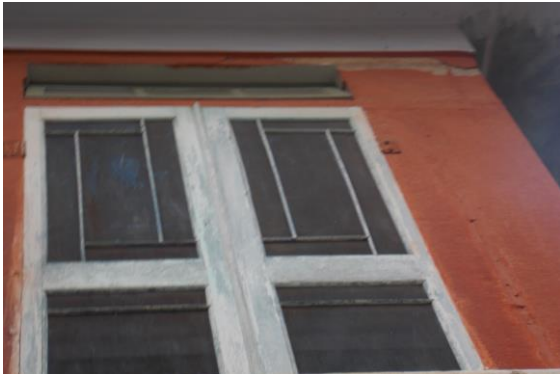
Photo 84

Peeling of Plaster on Sunshade of Building of Ground Floor

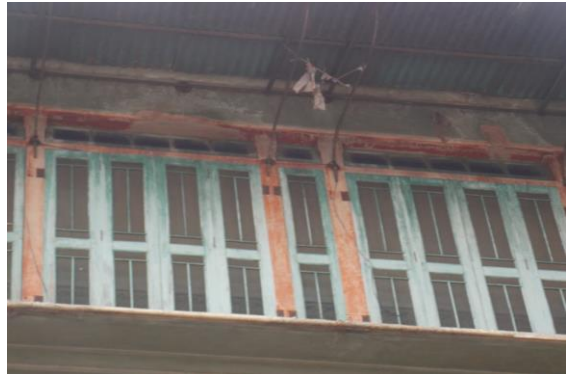
Photo 85

Peeling of Plaster on Frontside Wall of Building of First Floor

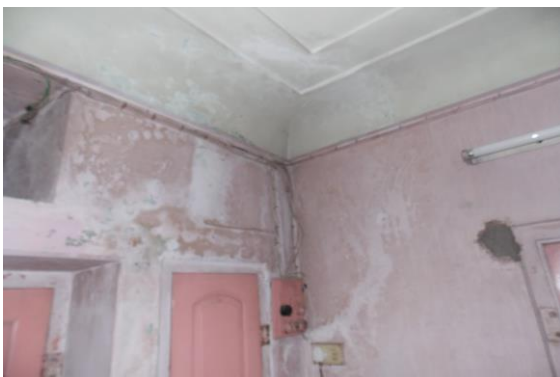
Photo 86

Peeling of Plaster on Leftside Wall of Building of Third Floor

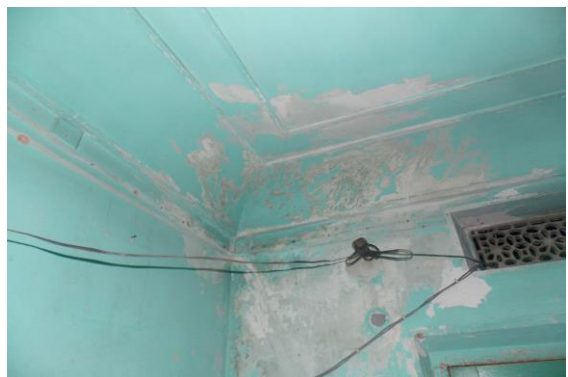
Photo 87

Dampness/Seepage on Wall No. 1, 3 & Roof of Hall No. 1 of First Floor

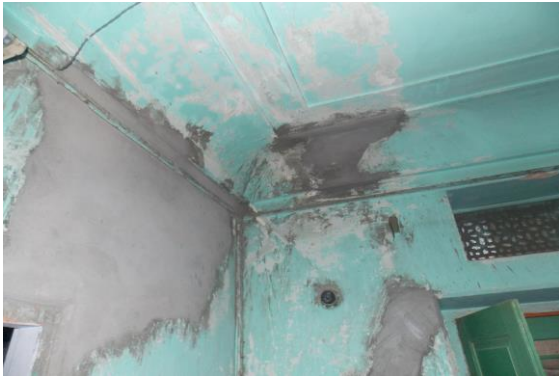
Photo 88

Peeling of Plaster on Wall No. 2, 3 & Roof of Room No. 2 of Second Floor

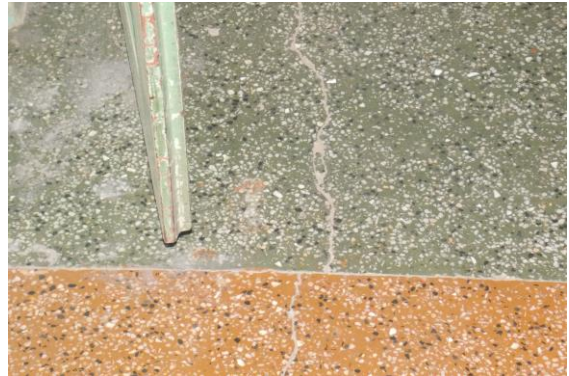
Photo 89

Damaged Portion on Wall No. 1, 4 & Roof of Room No. 2 of Second Floor

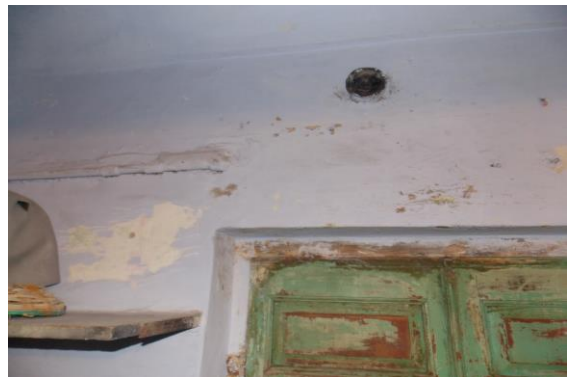
Photo 91

Dampness/Seepage on Wall No. 4, 2 & Roof of Kitchen of Second Floor

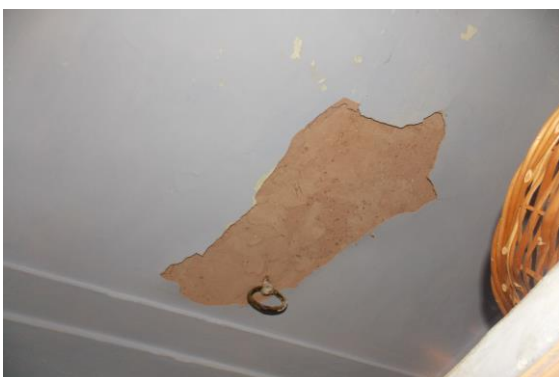
Photo 92

Peeling of Plaster on Wall No. 2 of Kitchen of Second Floor

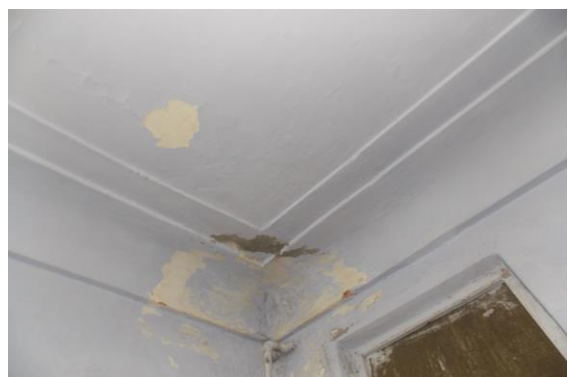
Photo 94

Peeling of Plaster on Wall No. 4 & Roof of Bathroom of Second Floor

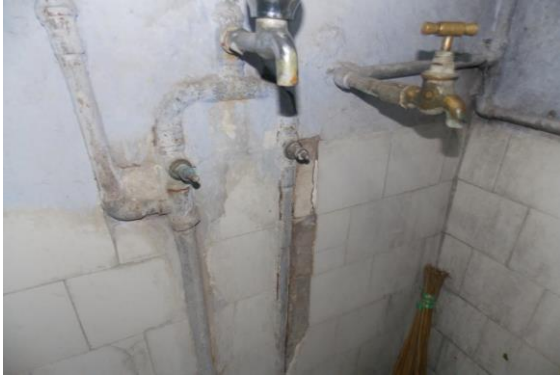
Photo 95  
Damaged Portion on Wall No. 4 of Bathroom of Second Floor

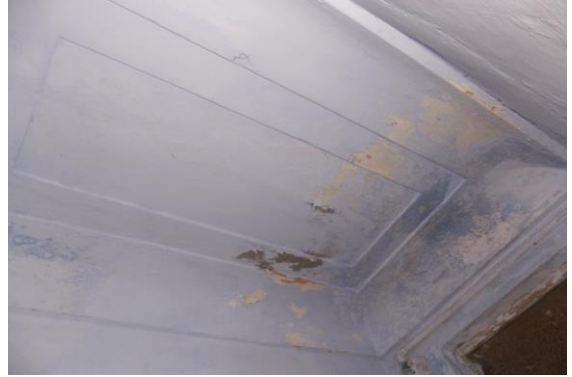
Photo 96  
Dampness/Seepage on Wall No. 4 & Roof of Toilet No. 1 of Second Floor

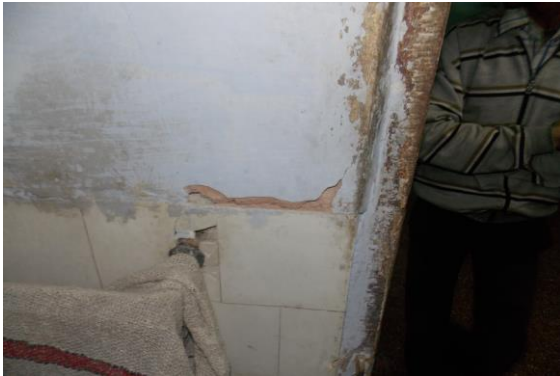
Photo 97  
Damaged Portion on Wall No. 2 of Toilet No. 1 of Second Floor

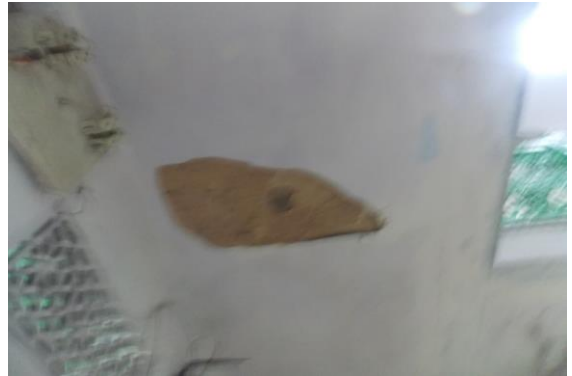
Photo 98  
Damaged Portion on Wall No. 1 & Sunshade of open area of Second Floor
