### Pre Building Condition Survey Report

Name and Address of Structure :	Badi Chopar to Ramp Area (UP Line)
---------------------------------	------------------------------------

Name of the Project	<b>Contract JMRC-UG1B</b> “Design and Construction of Tunnel between Chandpole and Badi Chouper and reverse line by Shield TBM, Underground Metro Stations at Choti Chouper and Badi Chouper by Cut and Cover Methods on East West Corridor of Jaipur Metro Rail Corporation Limited .”	
Owner :

Pre Building Condition Survey Report Badi Chopar to Ramp Area (UP Line)

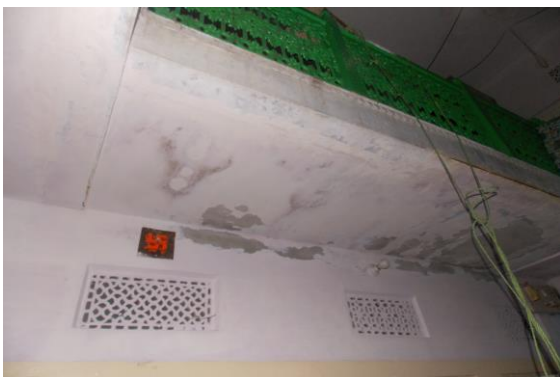
Photo 99  
Dampness/Seepage on Wall No. 4 & Sunshade of open area of Second Floor

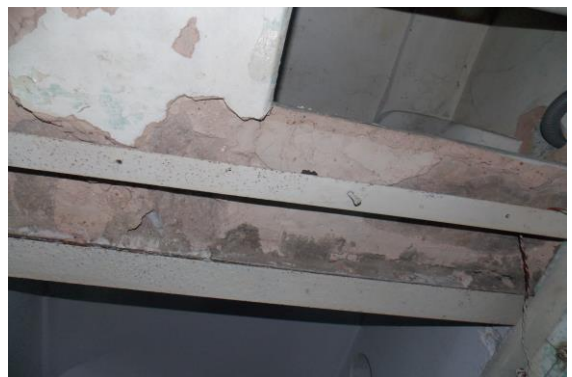
Photo 100  
Damaged Portion on Roof of Toilet No. 1 of Second Floor

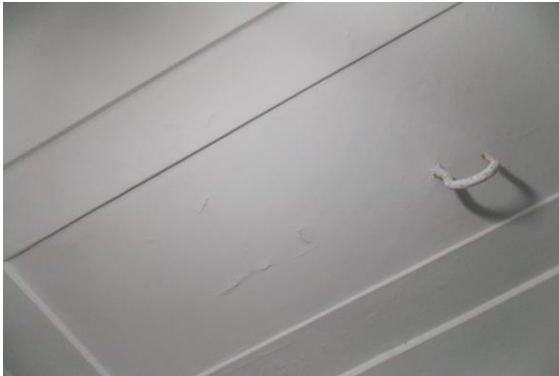
Photo 101  
Peeling of Plaster on Roof of Kitchen No.2 of Second Floor

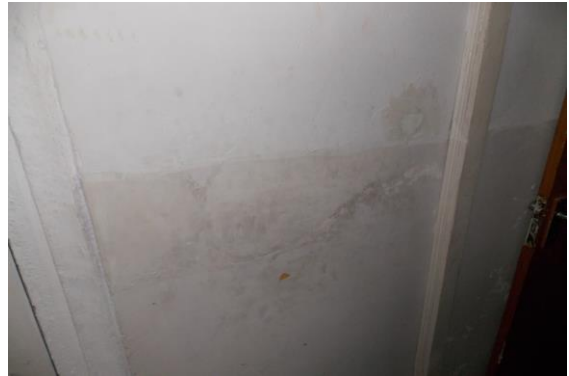
Photo 102  
Dampness/Seepage on Wall No. 2 of Hall No. 3 of Second Floor

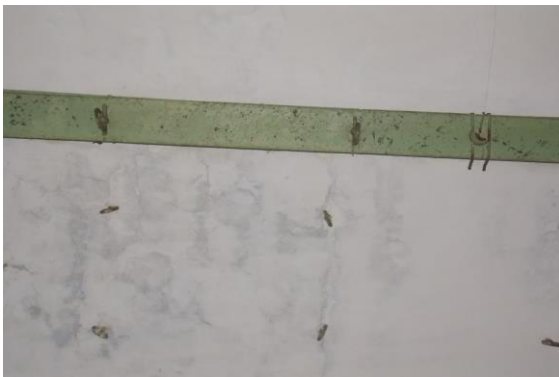
Photo 103  
Dampness/Seepage on Roof of Hall No. 1 of Second Floor

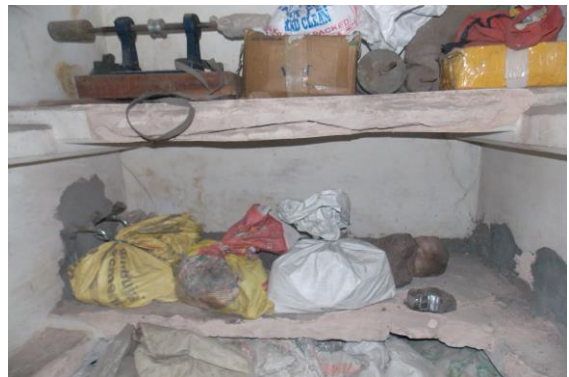
Photo 104  
Damaged Portion on Wall No. 4 of Store No.1 of Second Floor

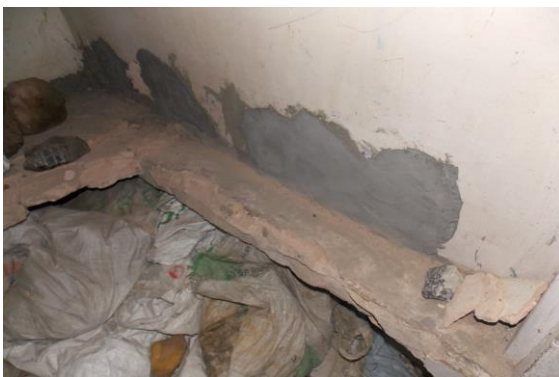
Photo 105  
Damaged Portion on Wall No. 2 of Store No.1 of Second Floor

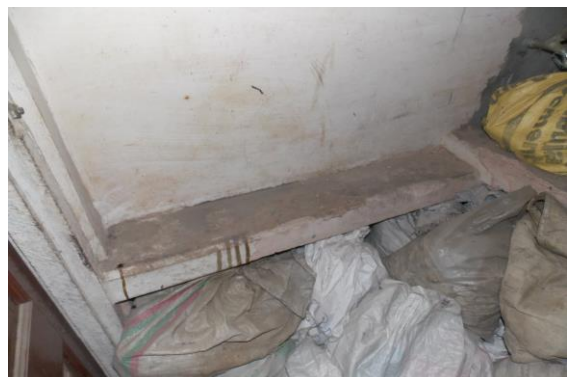
Photo 106  
Peeling of Plaster on Wall No. 1 of Store No.1 of Second Floor

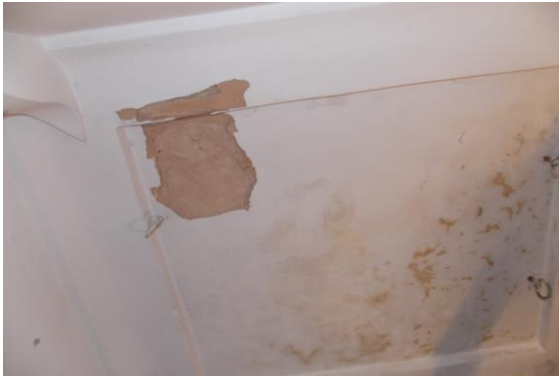
Photo 107  
Damaged Portion on Roof of Toilet No. 2 of Second Floor

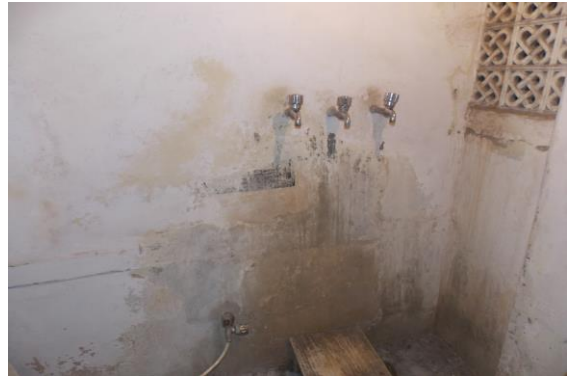
Photo 108  
Dampness/Seepage on Wall No. 4 of Toilet No. 2 of Second Floor

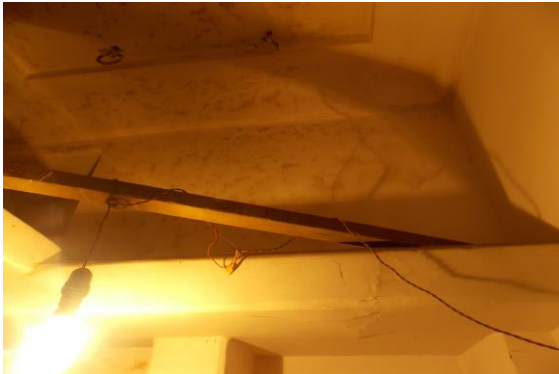
Photo 109  
Dampness/Seepage on Roof & 2 of Toilet No. 2 of Second Floor

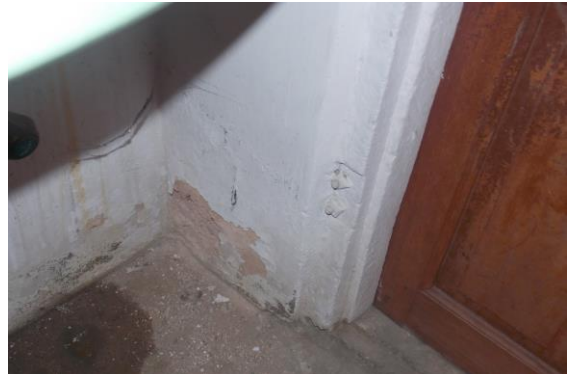
Photo 110  
Damaged Portion on Wall No. 3 of Toilet No. 2 of Second Floor

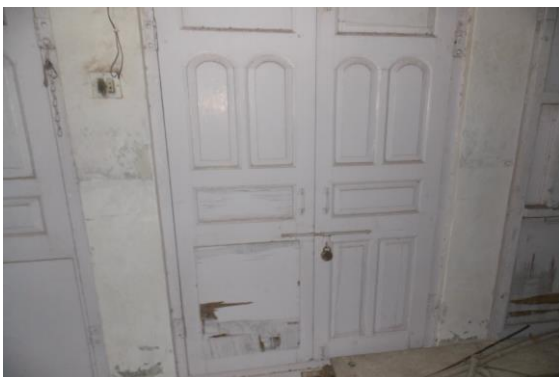
Photo 111  
Dampness/Seepage on All Walls & Roof of Toilet No. 1 of Fourth Floor

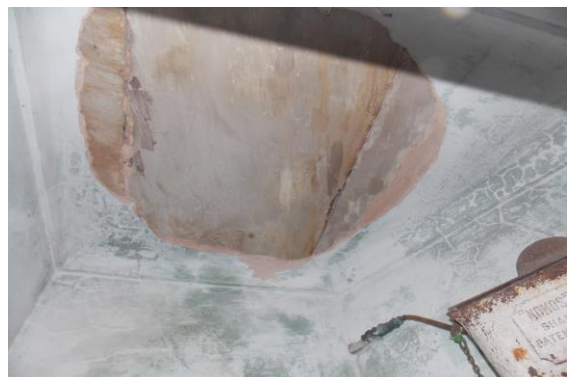
Photo 112  
Peeling of Plaster on Roof of Toilet No. 2 of Fourth Floor

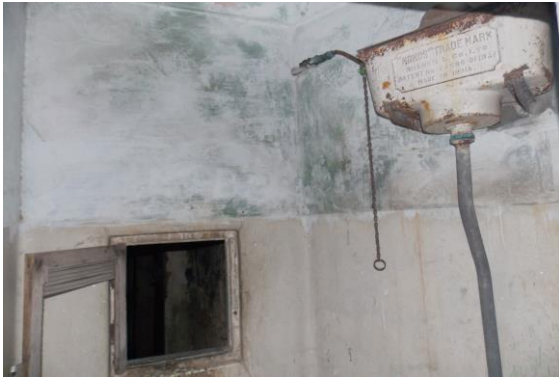
Photo 113  
Dampness/Seepage on All Walls of Toilet No. 2 of Fourth Floor

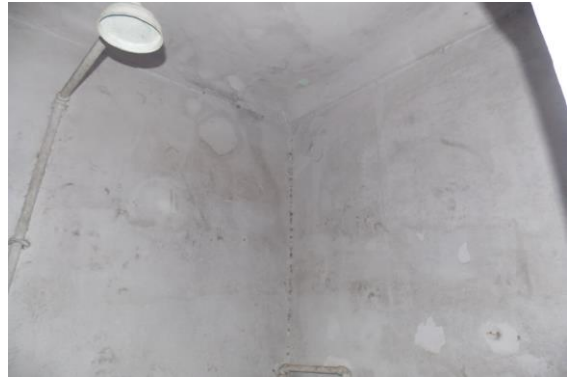
Photo 114  
Dampness/Seepage on Room No. 3 of Fourth Floor

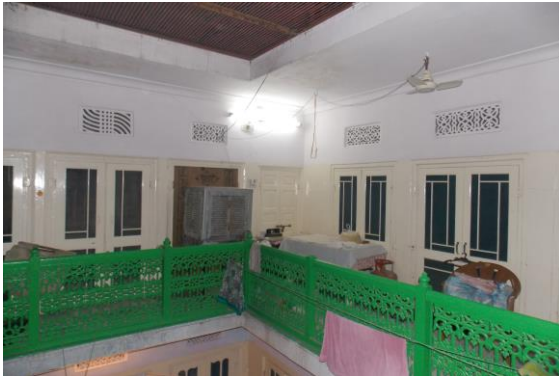
Photo 115  
Damaged Portion on of Third Floor

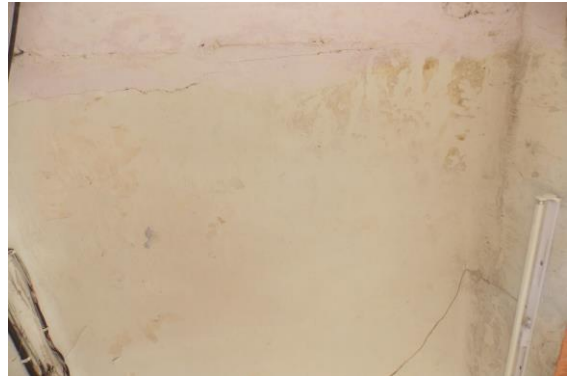
Photo 116  
Dampness/Seepage on of Varandah Roof of Shop No. 332, Ground Floor

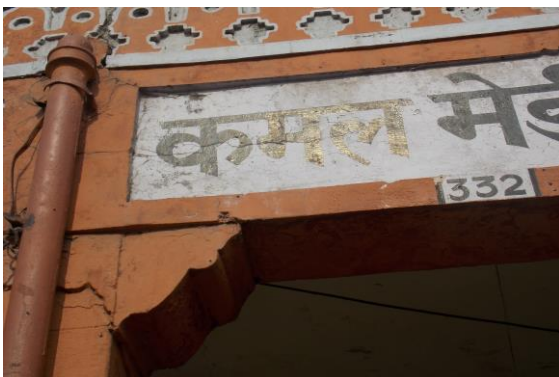
Photo 117  
Peeling of Plaster on Outer Wall of Shop No. 332 of Ground Floor

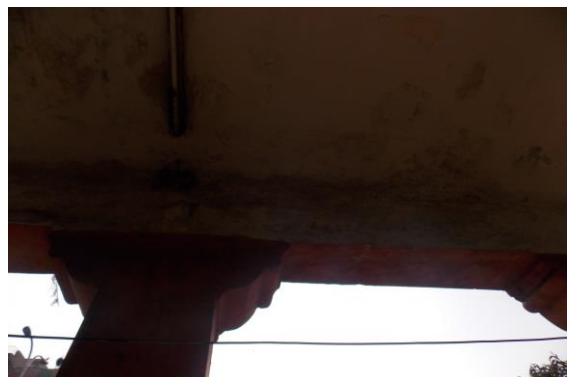
Photo 118  
Dampness/Seepage on Varanda Roof of Shop No. 332, Ground Floor

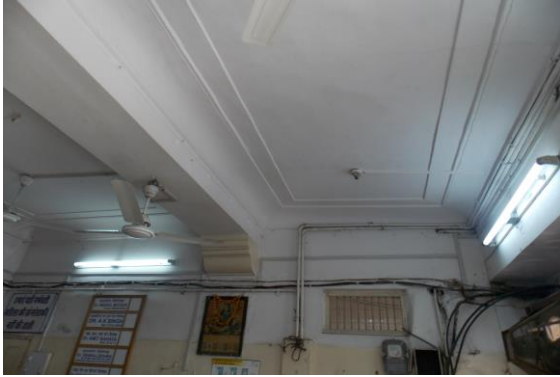
Photo 119

Peeling of Plaster on Wall No. 2 of Shop No. 334 of Ground Floor

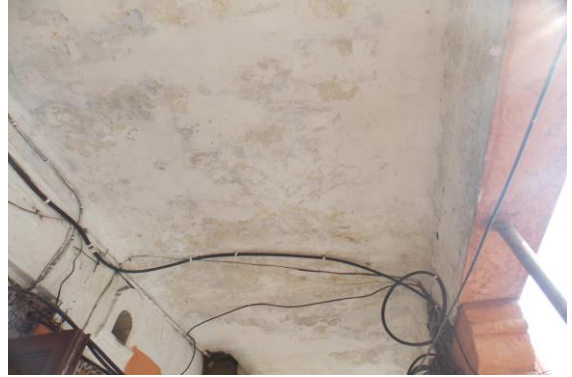
Photo 120

Dampness/Seepage on Varanda of Shop No. 334, Ground Floor

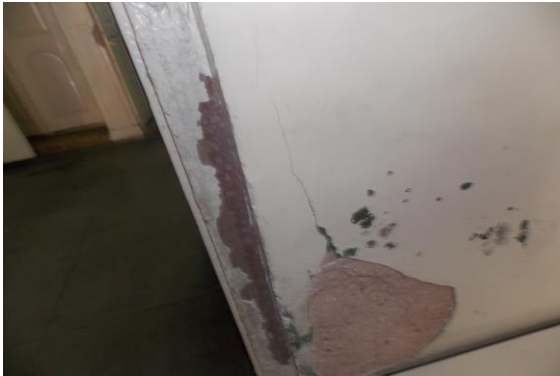
Photo 121

Peeling of Plaster on Wall No. 4 of Shop No. 334 of Ground Floor

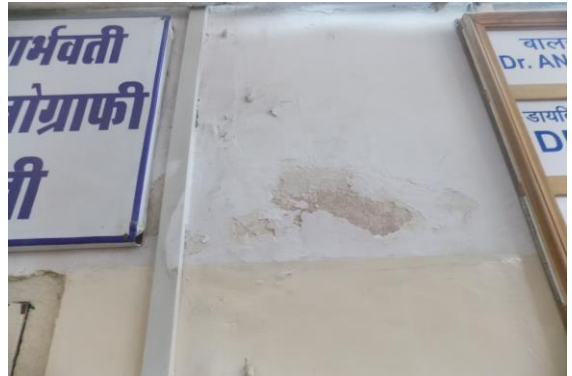
Photo 122

Peeling of Plaster on Wall No. 2 of Shop No. 334 of Ground Floor

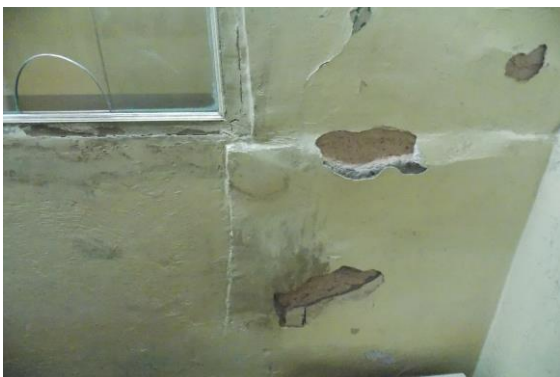
Photo 123

Peeling of Plaster on Wall No. 2 of First Floor

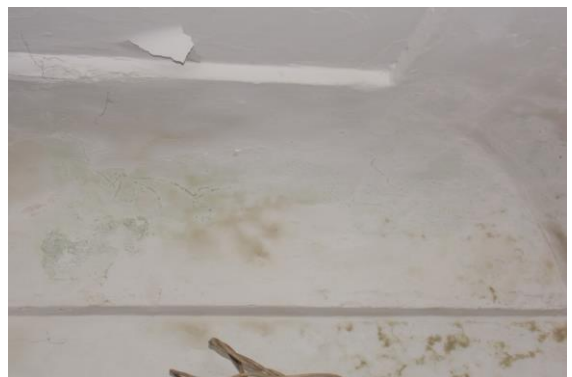
Photo 124

Dampness/Seepage on Wall No. 4 & Roof of Room No. 1 of First Floor

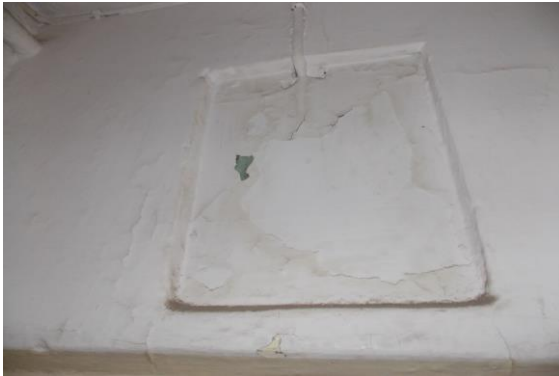
Photo 125  
Peeling of Plaster on Wall No. 4 of First Floor

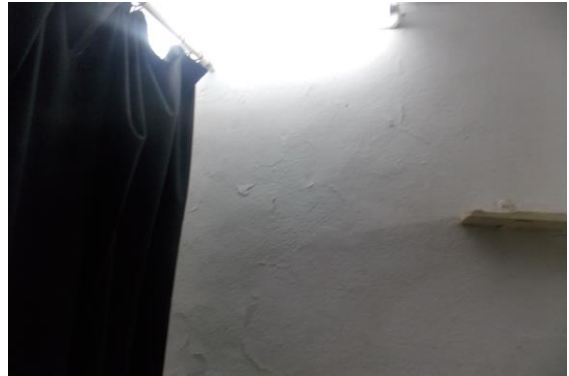
Photo 126  
Peeling of Plaster on Wall No. 4 of Room No. 2 of First Floor

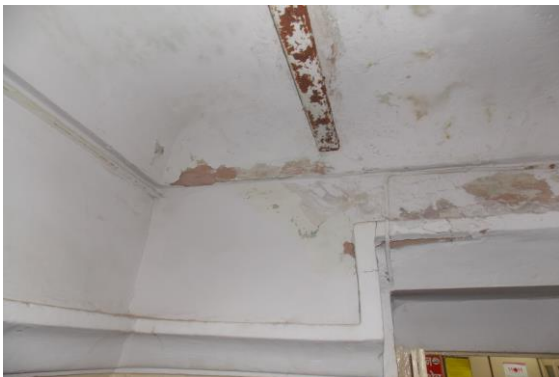
Photo 127  
Peeling of Plaster on Wall No. 4 of Lobby 2 of First Floor

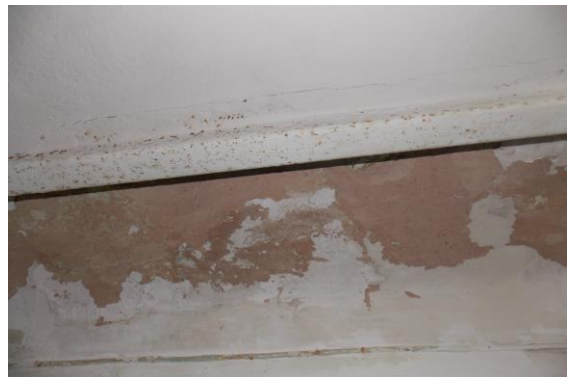
Photo 128  
Peeling of Plaster on Roof of First Floor

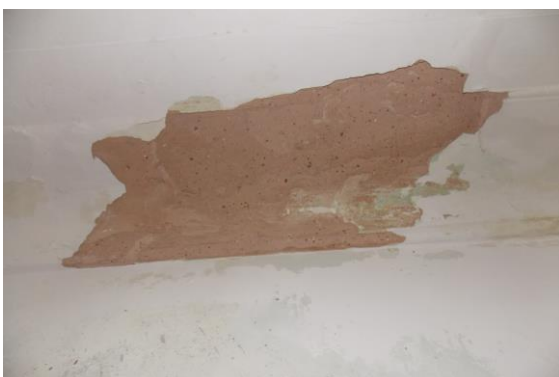
Photo 129  
Peeling of Plaster on Roof & 3 of Room No. 5 of First Floor

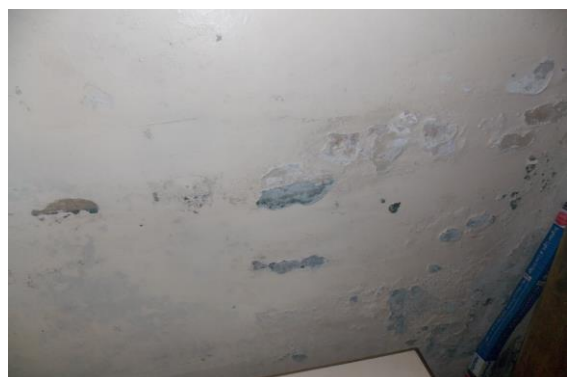
Photo 130  
Peeling of Plaster on Wall No. 2 of Room No. 5 of First Floor

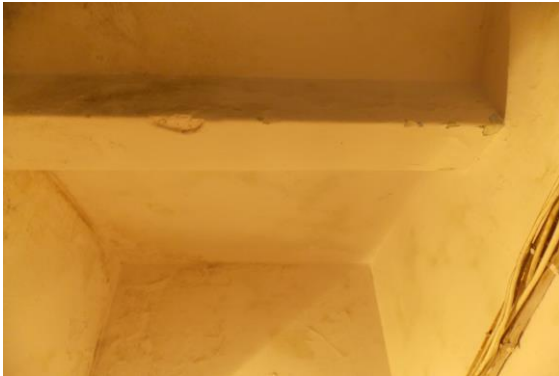
Photo 131  
Dampness/Seepage on Roof & 4 of Stair GF to FF

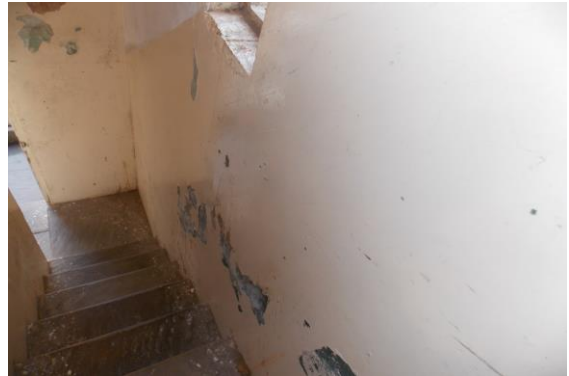
Photo 132  
Peeling of Plaster on Wall No. 1 of First Floor

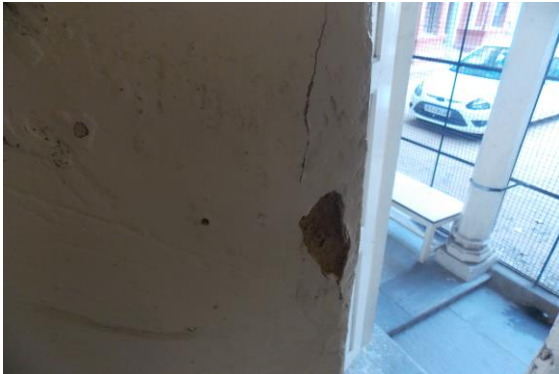
Photo 133  
Peeling of Plaster on Wall No. 2 of First Floor

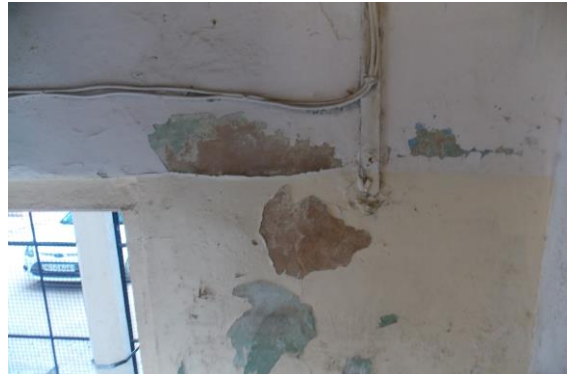
Photo 134  
Peeling of Plaster on Wall No. 3 of First Floor

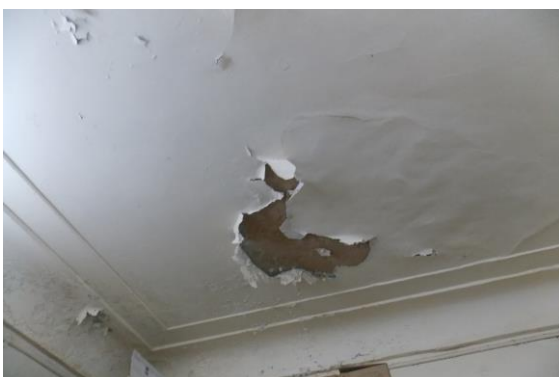
Photo 135  
Peeling of Plaster on Roof of Hall No. 1 of First Floor

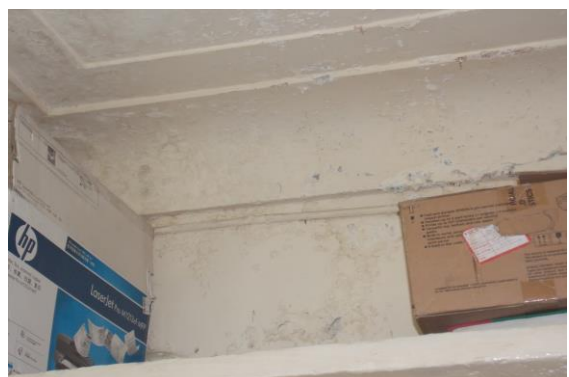
Photo 136  
Dampness/Seepage on Wall No. 2 of First Floor

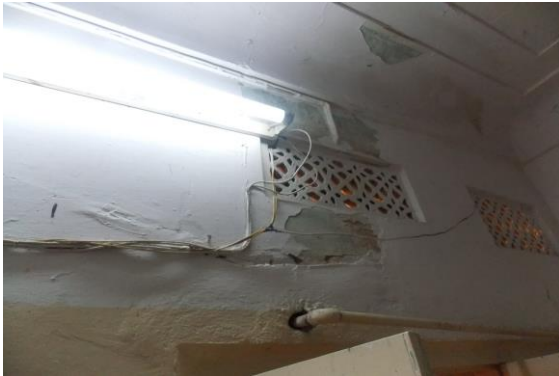
Photo 137  
Peeling of Plaster on Wall No. 1 of First Floor

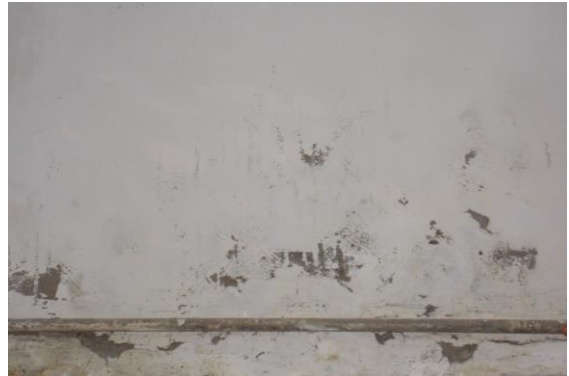
Photo 138  
Peeling of Plaster on Wall No. 4 of First Floor

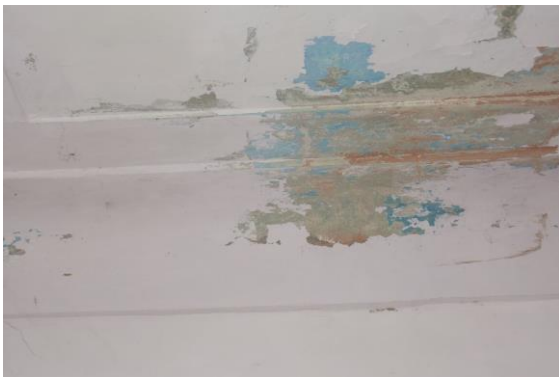
Photo 139  
Peeling of Plaster on Roof of First Floor

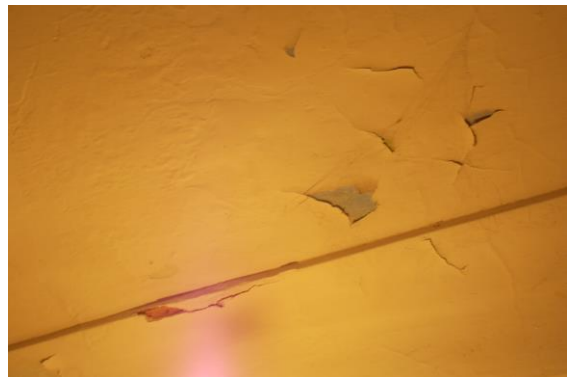
Photo 140  
Peeling of Plaster on Roof of Toilet No. 1 of First Floor

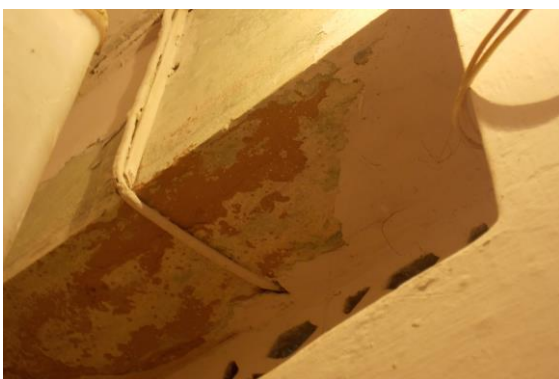
Photo 141  
Peeling of Plaster on Wall No. 3 of Toilet No. 1 of First Floor

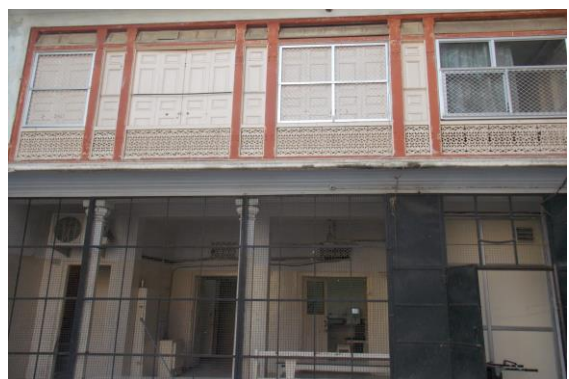
Photo 142  
Damaged Portion on Back view

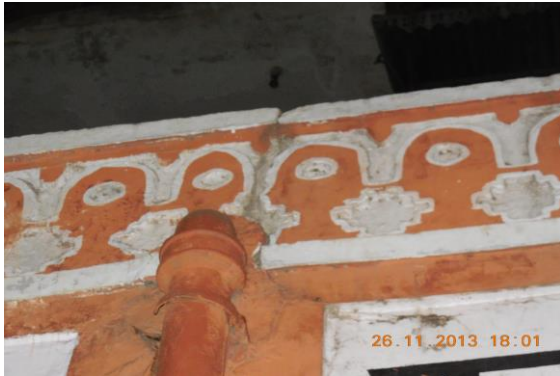
Photo 143

Damaged Portion on Outerwall & Leftside External Column Beam of Varanda of Shop No.332 of Ground Floor

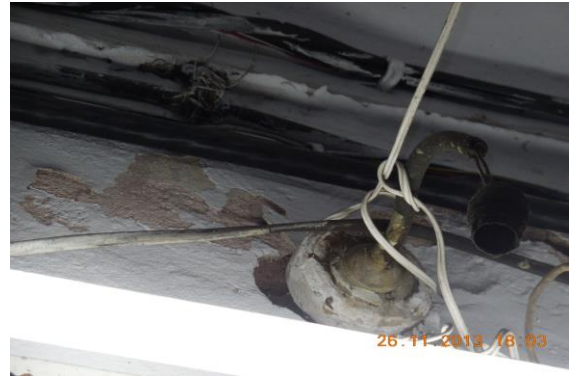
Photo 144

Dampness/Seepage on Outerwall 3 of Varanda of Shop No.332 of Ground Floor

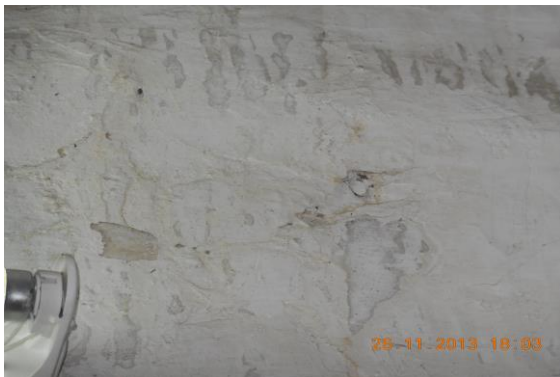
Photo 145

Peeling of Plaster on Roof of Varanda of Shop No.332 of Ground Floor

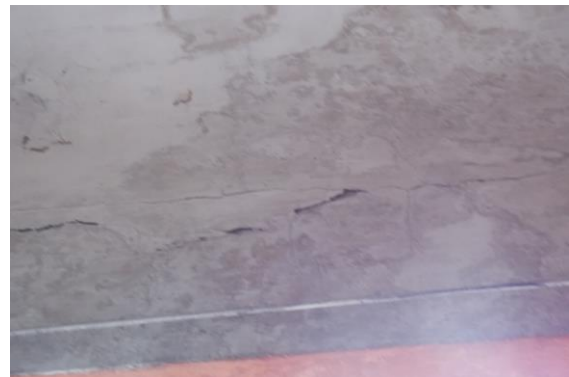
Summary of Cracks						
Defect ID	Location	Orientation	Appx. Width (mm)	Appx. Length (m)	Category	Photo No.
1	Roof Varanda of Shop No.331 Ground Floor	Horizontal	0.25	2.5	Very Slight	4
2	Wall No. 2 Room No. 1 House No. 44 E/20, Second Floor	Inclined	1	1	Slight	5, 5A

Photo 4  
Horizontal Crack on Roof of Varanda of Shop No.331, Ground Floor  
Approx. Width = 0.25mm, Approx. Length = 2.5m. Distance from =  
Right side external column, Height from Floor = 3.3m.

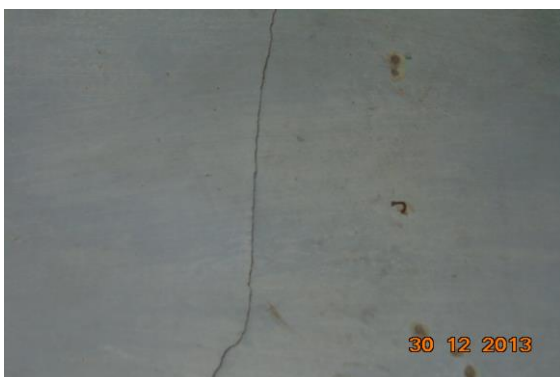
Photo 5  
Inclined Crack on Wall No. 2 of Room No. 1, House No. 44 E/20,  
Second Floor Approx. Width = 1mm, Approx. Length = 1m. Distance  
from Wall 4 = 1m, Height from Floor = 1.65m.

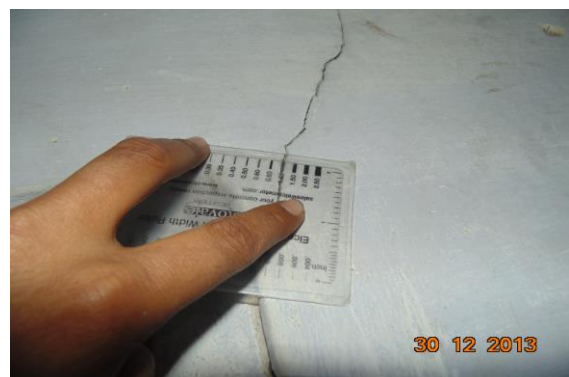
Photo 5A  
Inclined Crack on Wall No. 2 of Room No. 1, House No. 44 E/20,  
Second Floor Approx. Width = 1mm, Approx. Length = 1m. Distance  
from Wall 4 = 1m, Height from Floor = 1.65m.

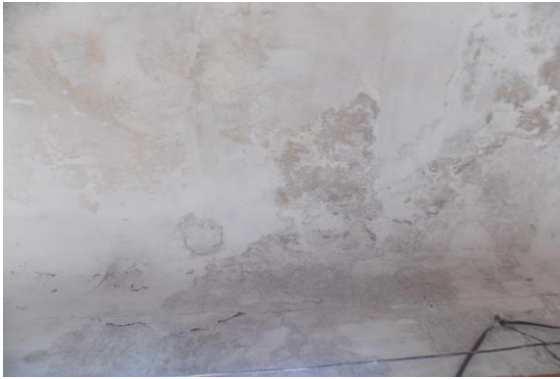
Photo 6

Peeling of Plaster on Roof of Varanda of Shop No.331 of Ground Floor

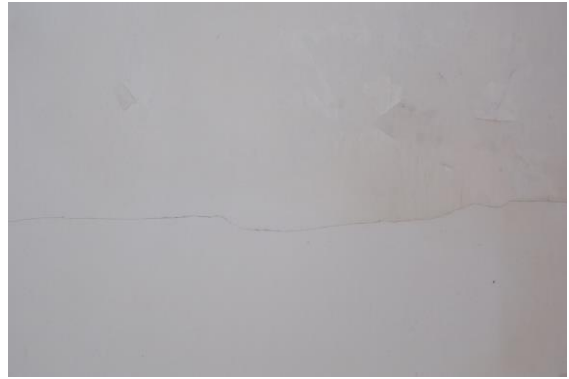
Photo 7

Peeling of Plaster on Roof of Varanda of Shop No.331 of Ground Floor

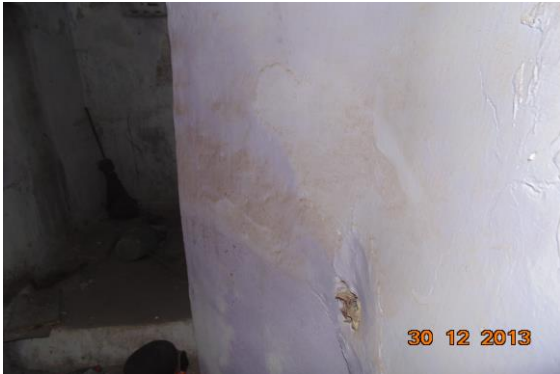
Photo 8

Dampness/Seepage on Wall No. 2 of Toilet No. 1 of House No. 44 E/20, First Floor

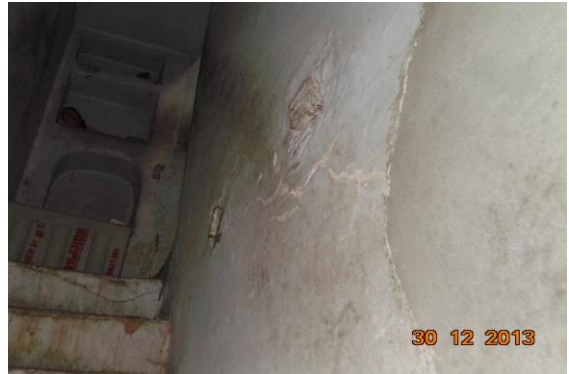
Photo 9

Peeling of Plaster on Wall No. 2 of Stair First Floor to Second Floor of House No. 44 E/20, First Floor

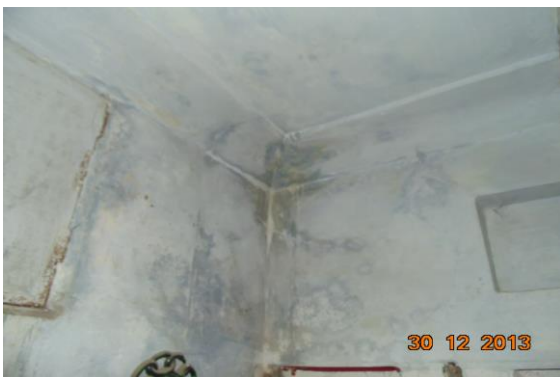
Photo 10

Dampness/Seepage on Wall No. 1, 4 & Roof of Room No. 1 of House No. 44 E/20, Second Floor

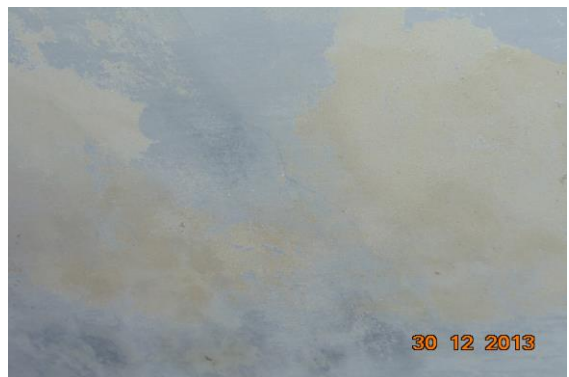
Photo 11

Dampness/Seepage on Roof of Room No.1 of House No. 44 E/20, Second Floor

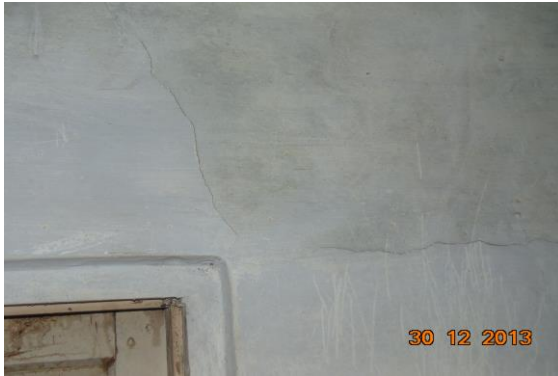
Photo 12

Plaster Crack on Wall No. 2 of Room No. 1 of House No. 44 E/20, Second Floor

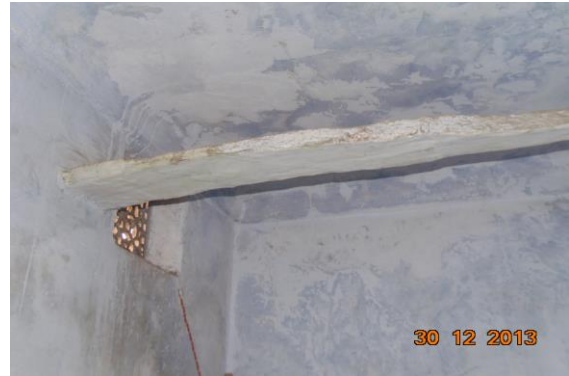
Photo 13

Dampness/Seepage on Wall No. 2, 3 & Roof of Room No. 1 of House No. 44 E/20, Second Floor

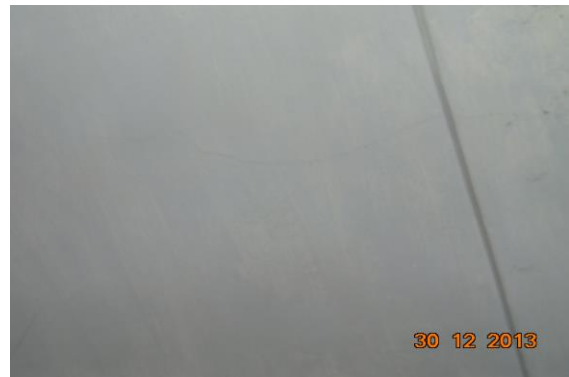
Photo 15

Plaster Crack on Roof of Room No. 1 of House No. 44 E/20, Second Floor

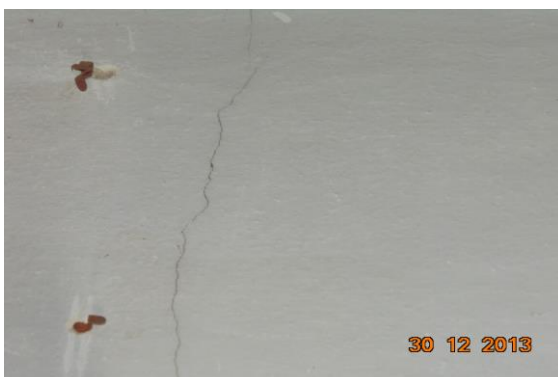
Photo 16

Plaster Crack on Wall No. 3 of Room No. 1 of House No. 44 E/20, Second Floor

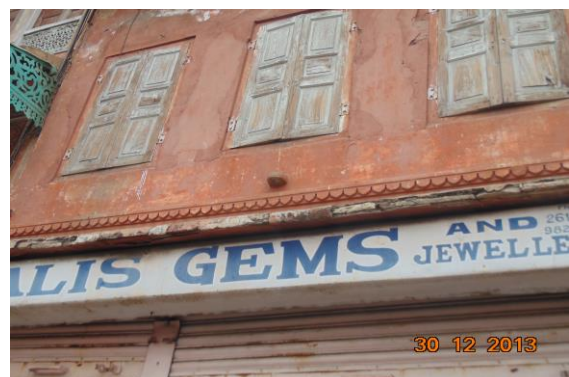
Photo 17

Damaged Portion on Wall No. 3 & Sunshade of External Façade at Front Side of House No. 44 E/20, First Floor

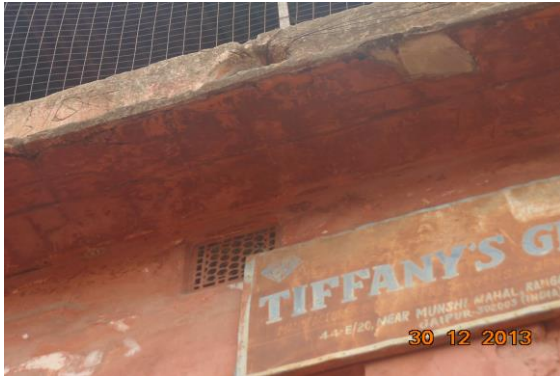
Photo 18

15	Wall No. 3 & Sunshade External Façade at Front Side House No. 44 E/20, Second Floor	Damaged Portion	18
16	Wall No. 3 & Sunshade External Façade at Front Side House No. 44 E/20, Second Floor	Damaged Portion	19

Damaged Portion on Wall No. 3 & Sunshade of External Façade at Front Side of House No. 44 E/20, Second Floor

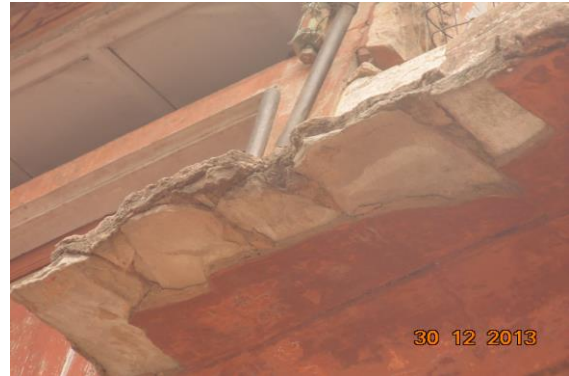
Photo 19

Damaged Portion on Wall No. 3 & Sunshade of External Façade at Front Side of House No. 44 E/20, Second Floor

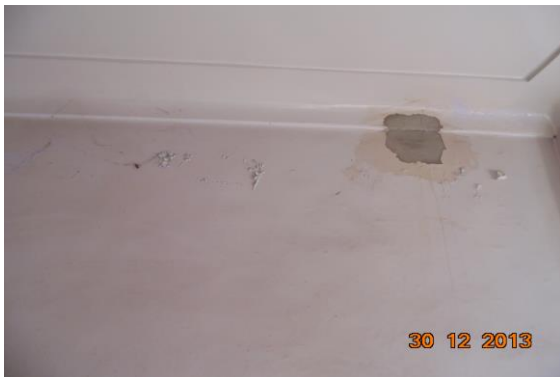
Photo 2  
Peeling of Plaster on Wall No. 4 of Room No. 1 of House No. 2469, First Floor

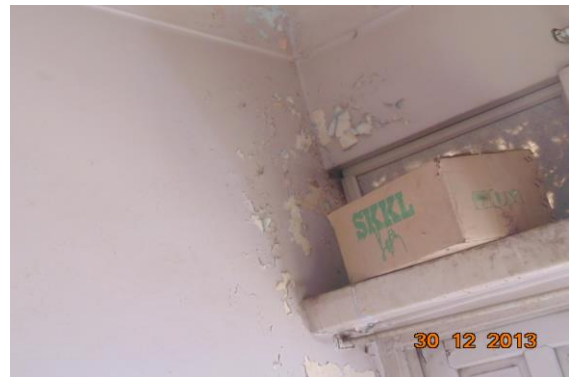
Photo 3  
Dampness/Seepage on Wall No. 2 & Roof of Room No. 1 of House No. 2469, First Floor

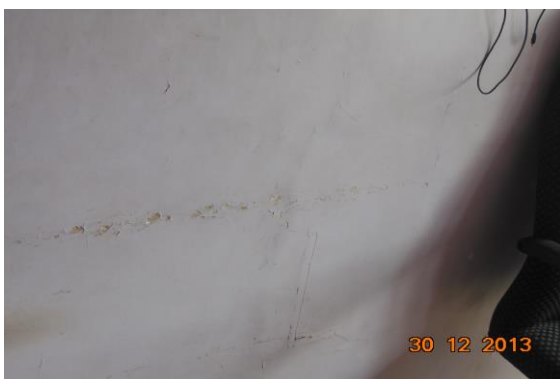
Photo 4  
Peeling of Plaster on Wall No. 1 of Room No. 1 of House No. 2469, Third Floor

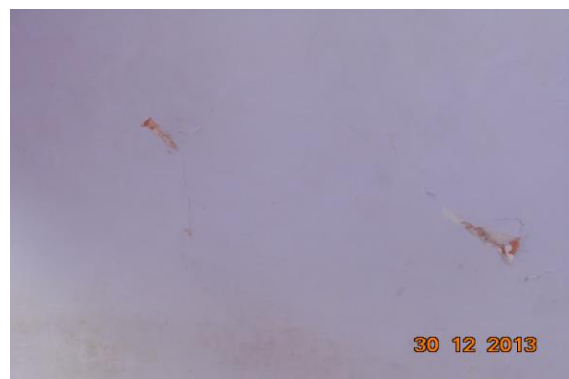
Photo 5  
Peeling of Plaster on Wall No. 2 of Room No. 1 of House No. 2469, Third Floor

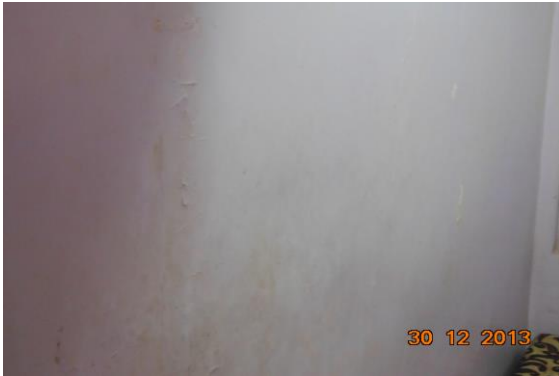
Photo 6

Peeling of Plaster on Wall No. 1 of Store of House No. 2469, Third Floor

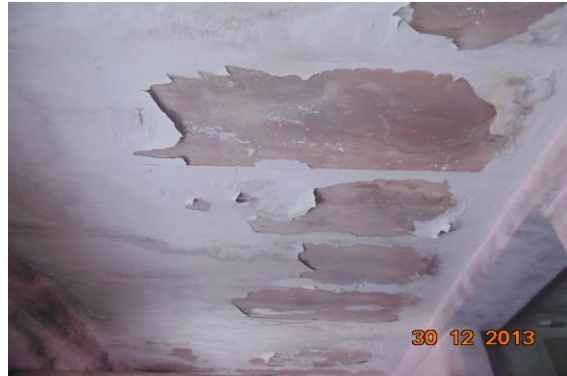
Photo 7

Peeling of Plaster on Roof of Room No. 1 of Terrace

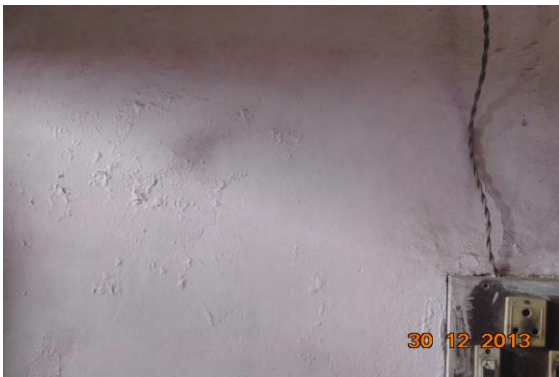
Photo 8

Peeling of Plaster on Wall No. 1 of House No. 2469 of Terrace

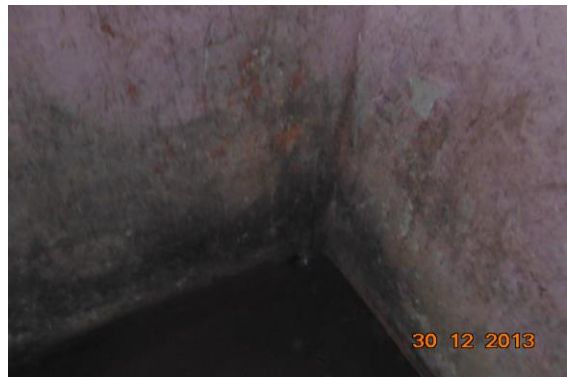
Photo 9

Dampness/Seepage on Wall No. 2 & 4 of House No. 2469 of Terrace

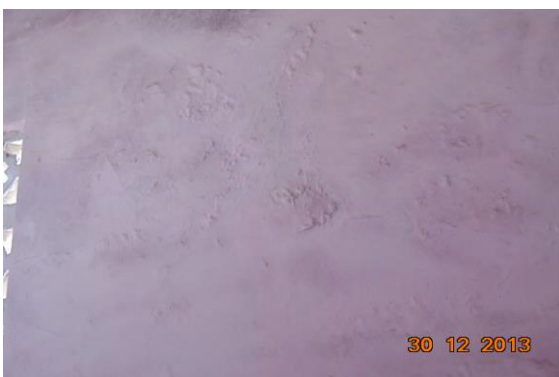
Photo 10

Dampness/Seepage on Wall No. 4 of Toilet No. 1 of Terrace

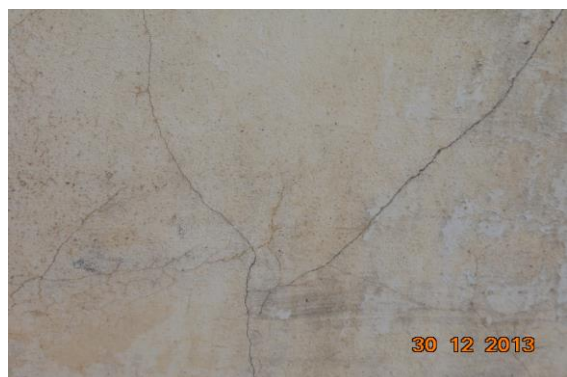
Photo 11

Plaster Crack on Wall No. 1 of Open Sky of House No. 2469, Terrace

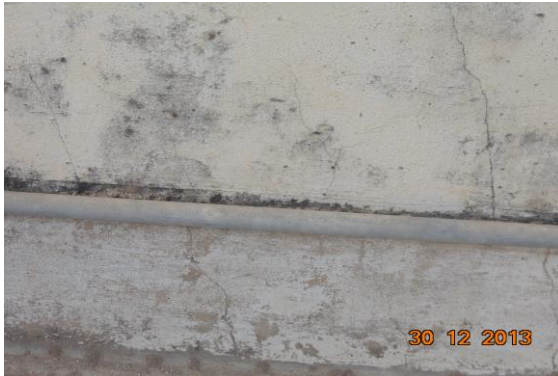
Photo 12  
Plaster Crack on Wall No. 2 of Open Sky of House No. 2469, Terrace

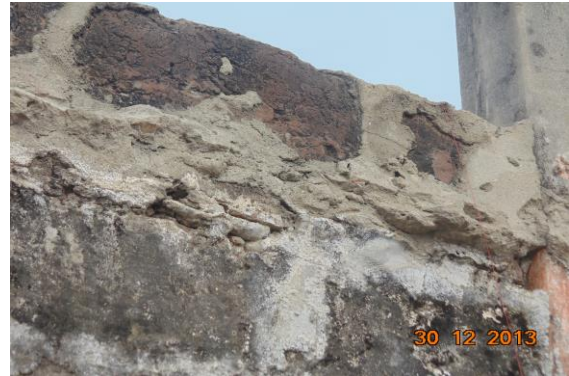
Photo 13  
Peeling of Plaster on Wall No. 3 of Open Sky of House No. 2469, Terrace

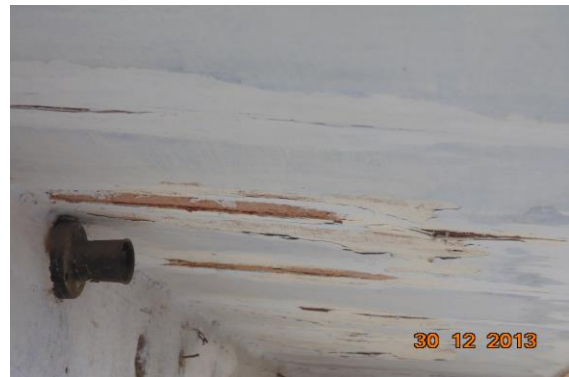
Photo 15  
Peeling of Plaster on Wall No. 3 & Sunshade of Open Sky of House No. 2469, Terrace

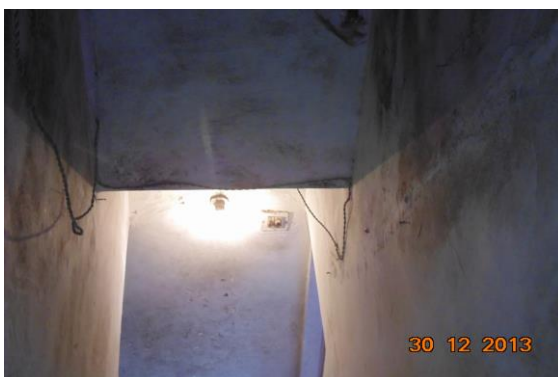
Photo 16  
Dampness/Seepage on Wall No. 1, 2, 3 & Roof of Stair Third Floor to Terrace of House No. 2469, Terrace

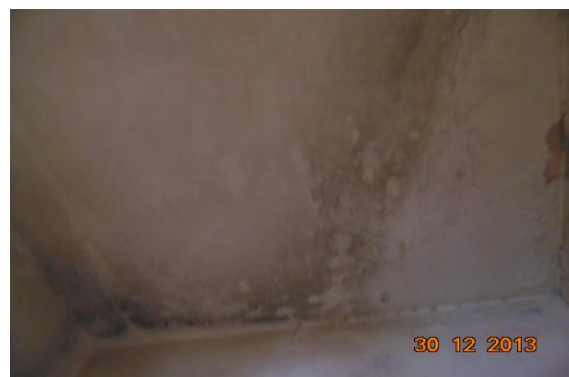
Photo 17  
Dampness/Seepage on Roof of Stair Third Floor to Terrace of House No. 2469, Terrace

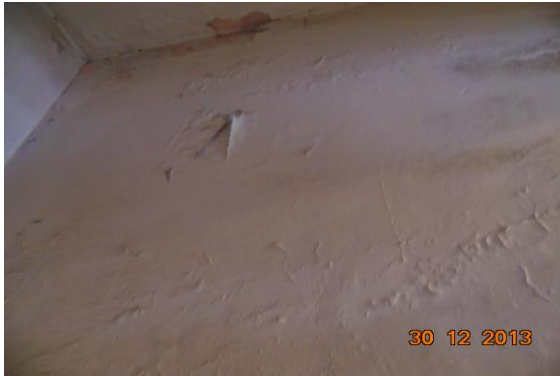
Photo 18

Dampness/Seepage on Wall No. 1 of Stair Third Floor to Terrace of House No. 2469, Terrace

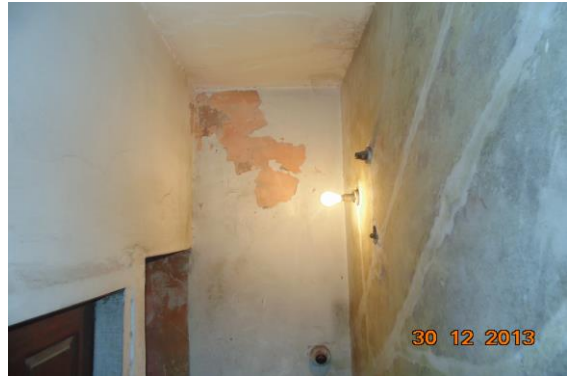
Photo 19

Dampness/Seepage on Wall No. 1, 2, 3 & Roof of Stair Third Floor to Terrace of House No. 2469, Terrace

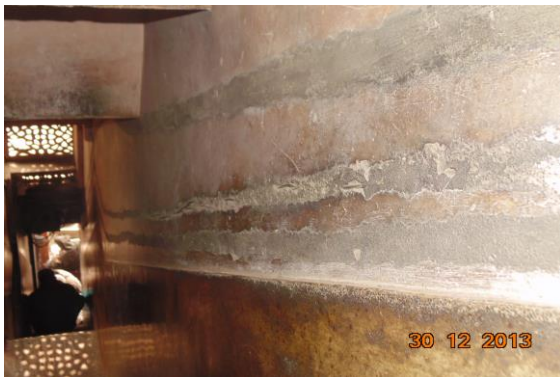
Photo 20

Peeling of Plaster on Wall No. 1 of Stair First Floor to Second Floor of House No. 2469, Second Floor

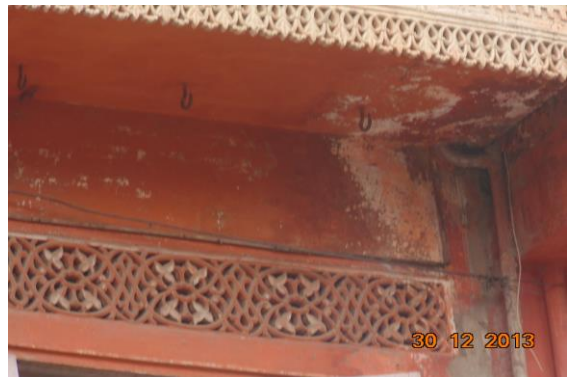
Photo 21

Dampness/Seepage on Wall No. 3 & Sunshade of House No. 2469 of First Floor

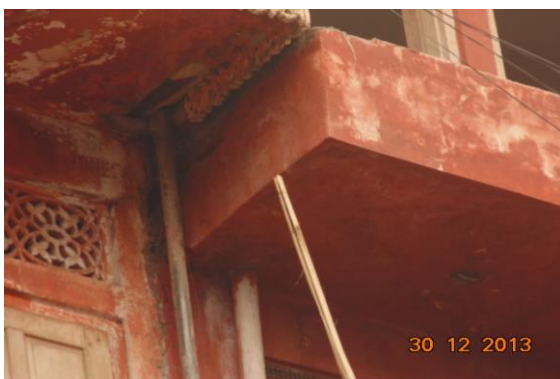
Photo 22

Dampness/Seepage on Wall No. 3 & Sunshade of House No. 2469 of Second Floor

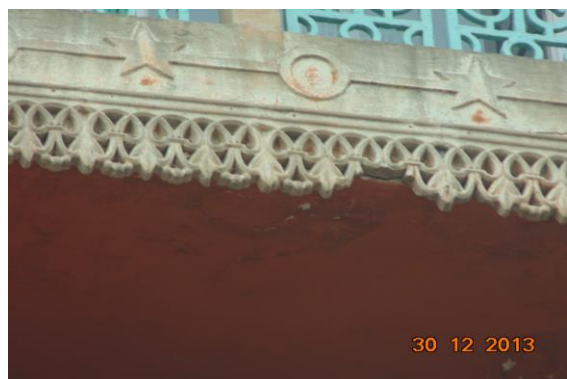
Photo 23

Damaged Portion on Wall No. 3 & Sunshade of House No. 2469 of Second Floor

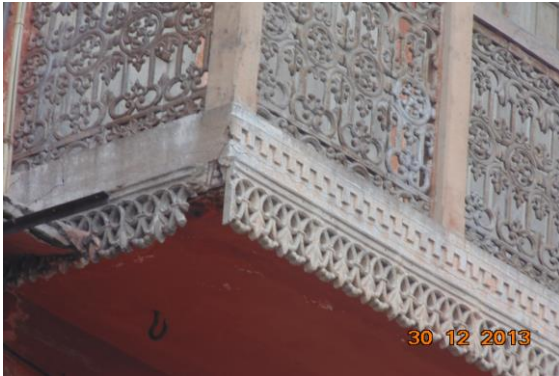
Photo 24

Damaged Portion on Wall No. 3 & Sunshade of House No. 2469 of First Floor

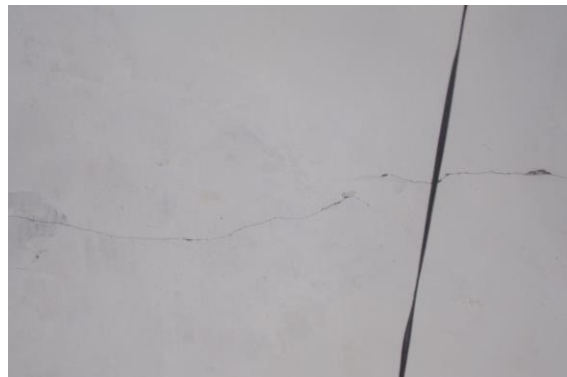
Photo 10  
Horizontal Crack on Roof of Varanda of Shop No.329, Ground Floor  
Approx. Width = 0.35mm, Approx. Length = 2m. Distance from =  
Backside of L.S. ext col, Height from Floor = 3.5m.

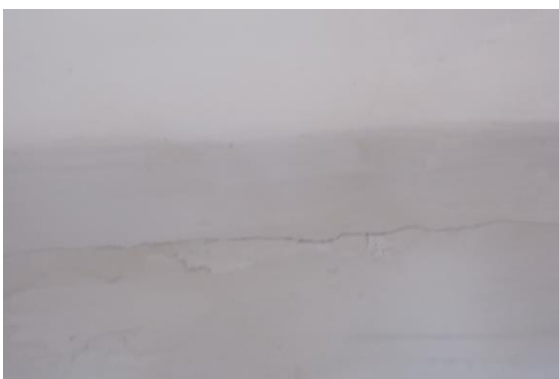
Photo 11  
Inclined Crack on External Beam Right side of Varanda of Shop No.329,  
Ground Floor Approx. Width = 0.35mm, Approx. Length = 2.5m.  
Distance from L.S. Ext Col = 0.6m, Height from Floor = 3.3m.

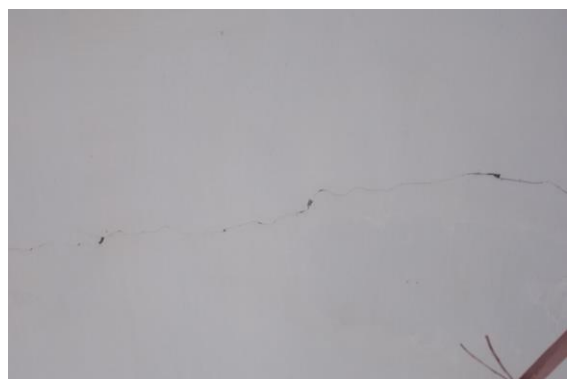
Photo 12  
Horizontal Crack on Roof of Varanda of Shop No.329, Ground Floor  
Approx. Width = 0.3mm, Approx. Length = 1.7m. Distance from  
Rightside External Column = 0.4m, Height from Floor = 3.5m.

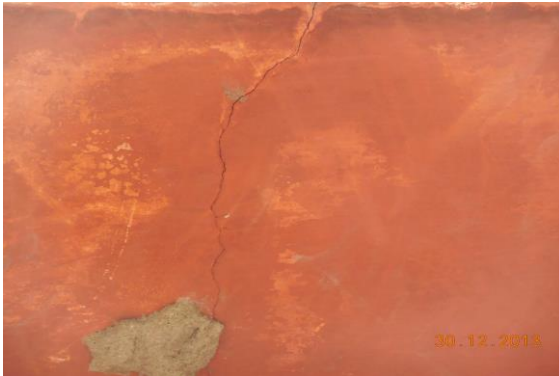
Photo 13

Inclined Crack on Sunshade of Parapit Wall, House No. 2465, First Floor Approx. Width = 0.25mm, Approx. Length = 0.5m. Distance from Wall No.2 = 1.5m, Height from Floor = 3m.

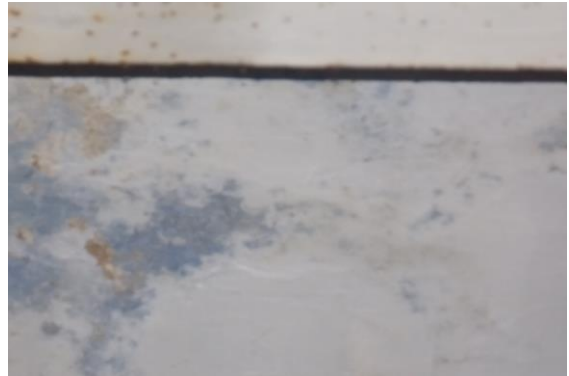
Photo 14

Dampness/Seepage on Roof of Shop No.329 of Ground Floor

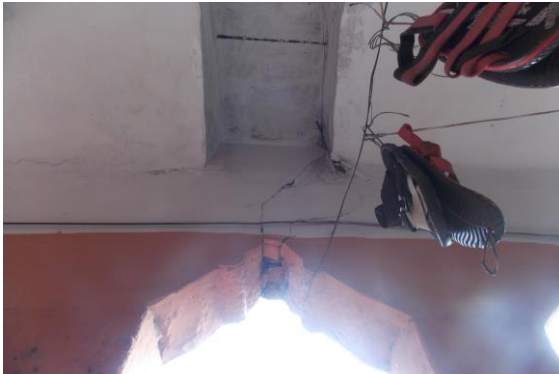
Photo 15

Peeling of Plaster on Right side External column of Varanda of Shop No.329 of Ground Floor

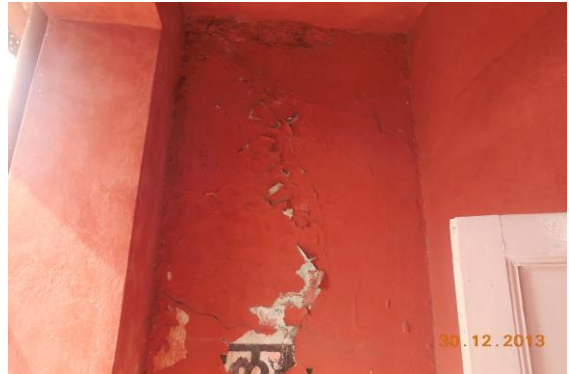
Photo 16

Peeling of Plaster on Wall No. 4 of Varanda of House No. 2466, First Floor

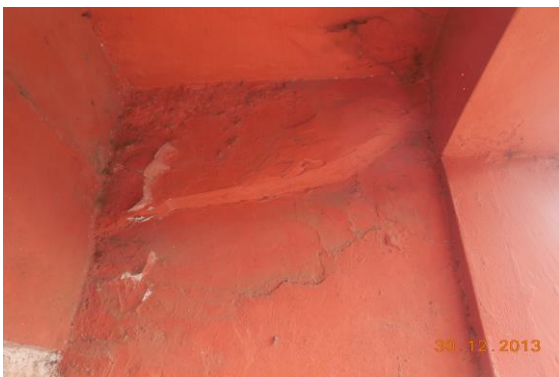
Photo 17

Peeling of Plaster on Wall No. 3 of External Wall of Varanda of House No. 2466, First Floor

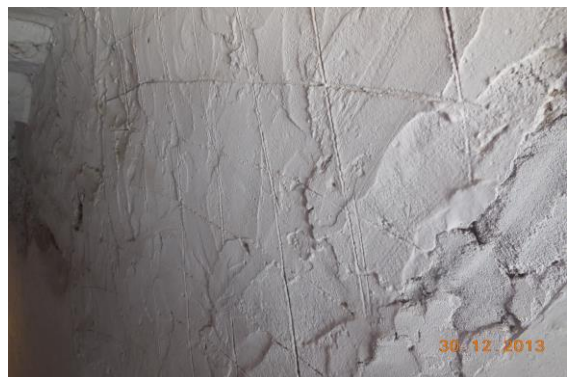
Photo 18

Peeling of Plaster on Staircase of House No. 2466, Second Floor

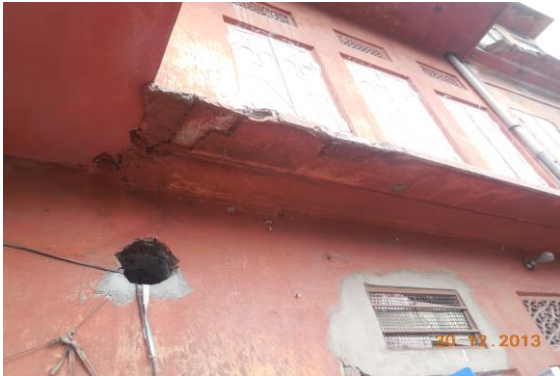
Photo 19

Peeling of Plaster on Sunshade of Parapit Wall of House No. 2465, First Floor

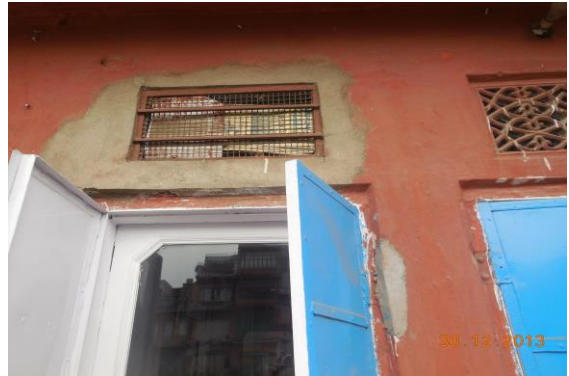
Photo 20

Peeling of Plaster on Sunshade of Parapit Wall of House No. 2465, First Floor
