### Pre Building Condition Survey Report

Name and Address of Structure :	Badi Chopar to Ramp Area (UP Line)
---------------------------------	------------------------------------

Name of the Project	<b>Contract JMRC-UG1B</b> “Design and Construction of Tunnel between Chandpole and Badi Chouper and reverse line by Shield TBM, Underground Metro Stations at Choti Chouper and Badi Chouper by Cut and Cover Methods on East West Corridor of Jaipur Metro Rail Corporation Limited .”	
Owner :

Pre Building Condition Survey Report Badi Chopar to Ramp Area (UP Line)

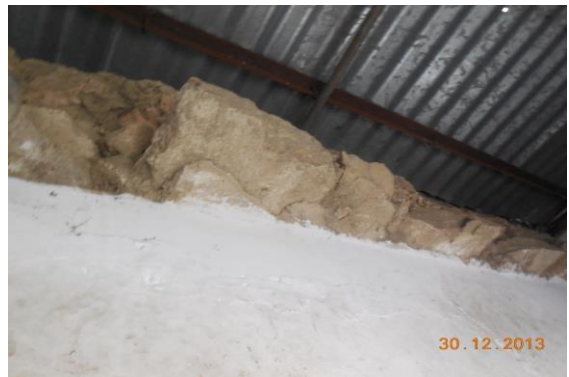
Photo 21

Peeling of Plaster on Wall No. 3 of Toilet No. 1 of House No. 2465, First Floor

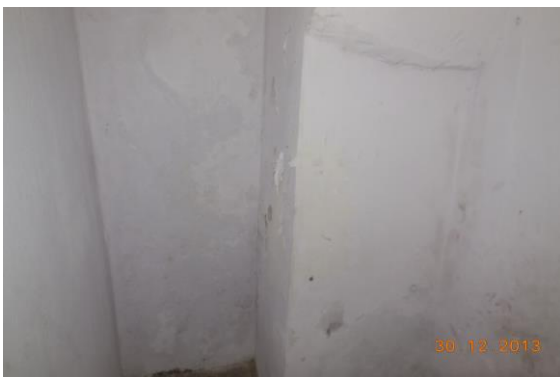
Photo 22

Peeling of Plaster on Wall No. 3 of Toilet No. 1 of House No. 2465, First Floor

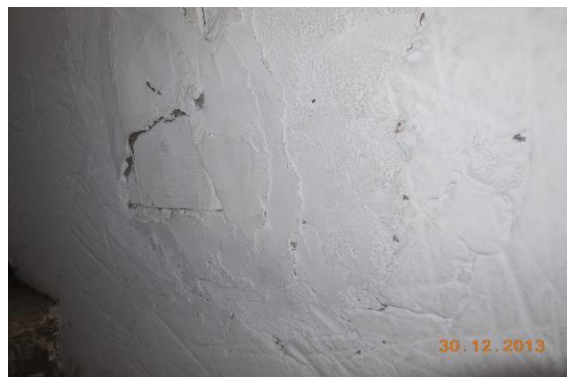
Photo 23

Dampness/Seepage on Wall No. 2 of Toilet No. 1 of House No. 2465, First Floor

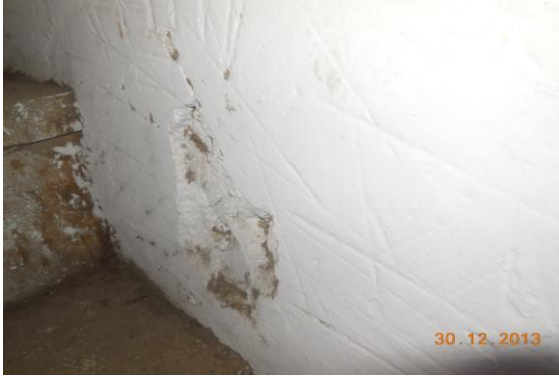
Photo 25

Dampness/Seepage on Wall No. 2 of Staircase First Floor to Second Floor of House No. 2465, First Floor

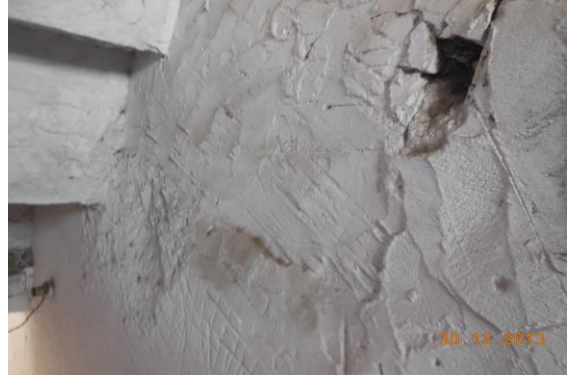
Photo 26

Damaged Portion on Wall No. 1 of Staircase First Floor to Second Floor of House No. 2465, First Floor

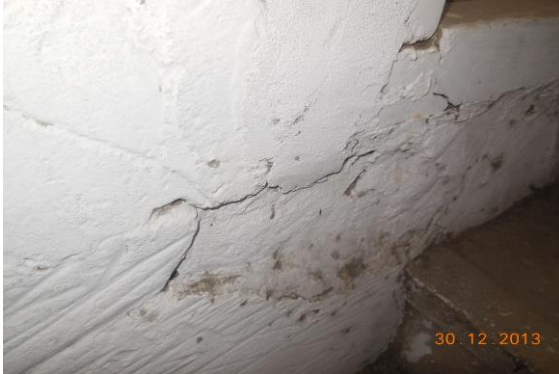
Photo 27

Damaged Portion on Wall No. 1 of Staircase First Floor to Second Floor of House No. 2465, First Floor

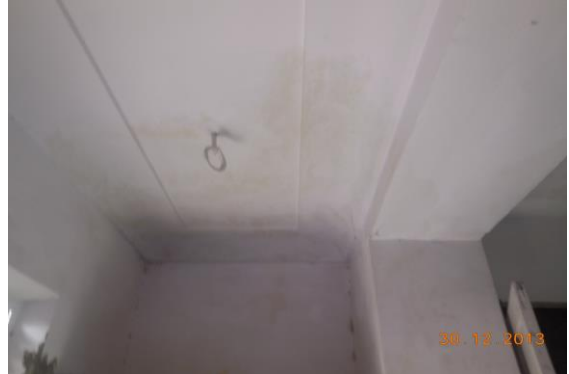
Photo 28

Dampness/Seepage on Roof of Room No. 1 of House No. 2465, Second Floor

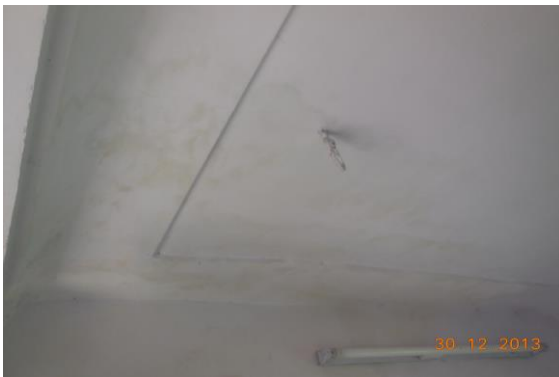
Photo 29

Dampness/Seepage on Roof of Room No. 1 of House No. 2465, Second Floor

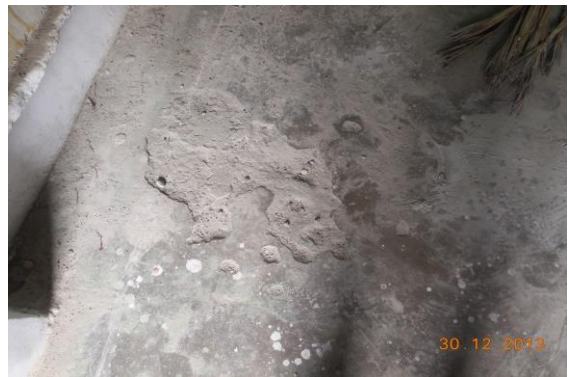
Photo 30

Peeling of Plaster on Floor of House No. 2465, Second Floor

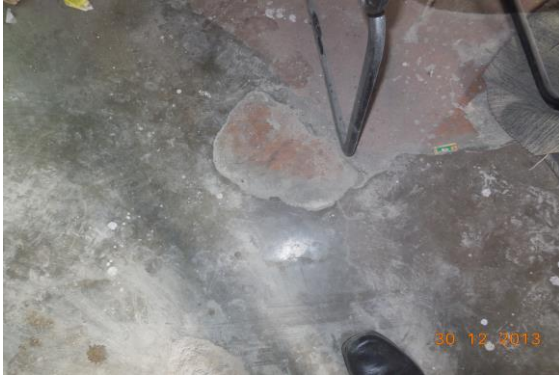
Photo 31  
Peeling of Plaster on Floor of House No. 2465, Second Floor

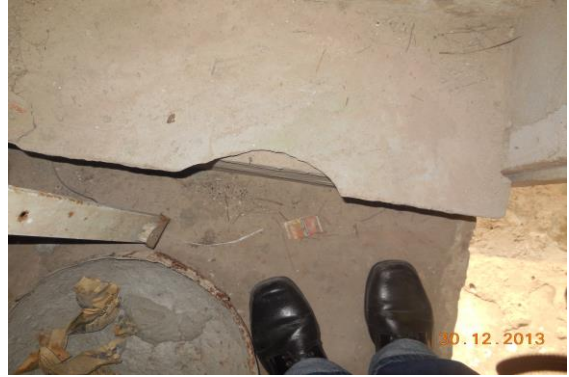
Photo 32  
Damaged Portion on Steps of Staircase Second Floor to Third Floor of House No. 2465, Second Floor

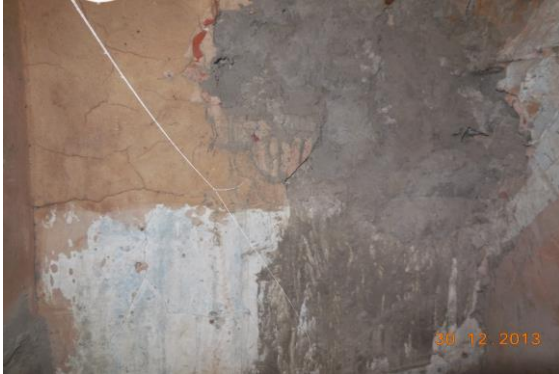
Photo 33  
Peeling of Plaster on Wall No. 3 of Staircase Second Floor to Third Floor of House No. 2465, Second Floor

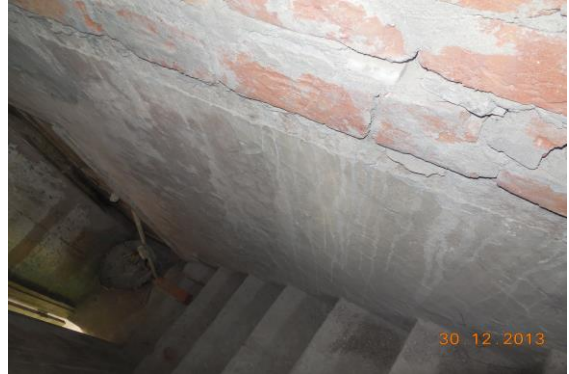
Photo 34  
Peeling of Plaster on Wall No. 1 of Staircase Second Floor to Third Floor of House No. 2465, Second Floor

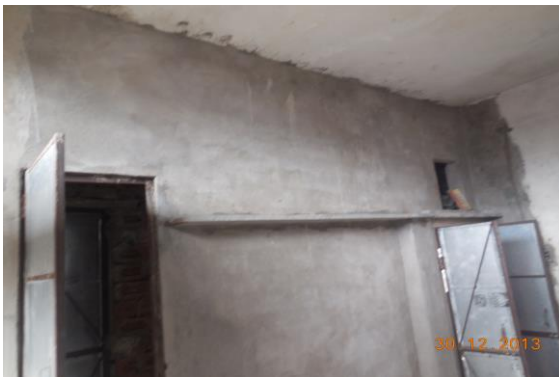
Photo 35  
Peeling of Plaster on of Room No. 1 of House No. 2465, Third Floor

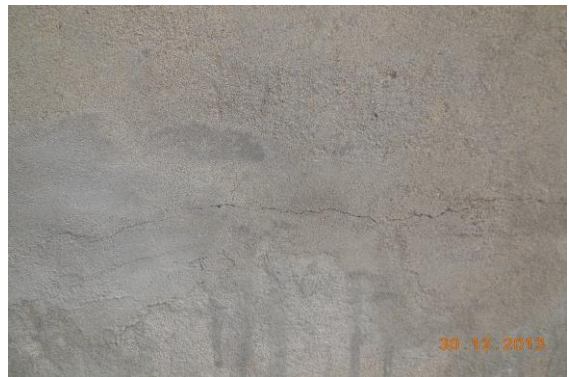
Photo 36  
Plaster Crack on Wall No. 1 of Balcony of House No. 2465, Third Floor

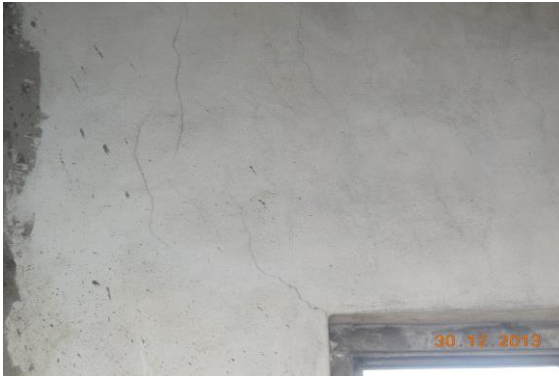
Photo 37

Plaster Crack on Wall No. 1 of Room No. 1 of House No. 2465, Third Floor

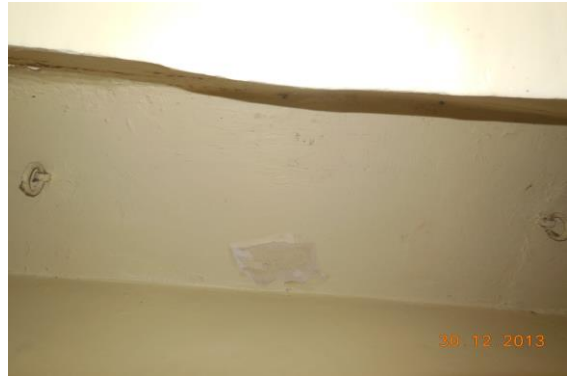
Photo 2  
Peeling of Plaster on Roof of Varanda 1 of House No. 2463, First Floor

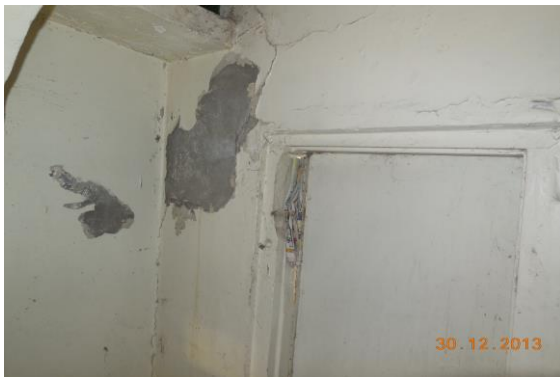
Photo 3  
Peeling of Plaster on Wall No. 1 & 4 of Varanda No.1 of House No. 2463, First Floor

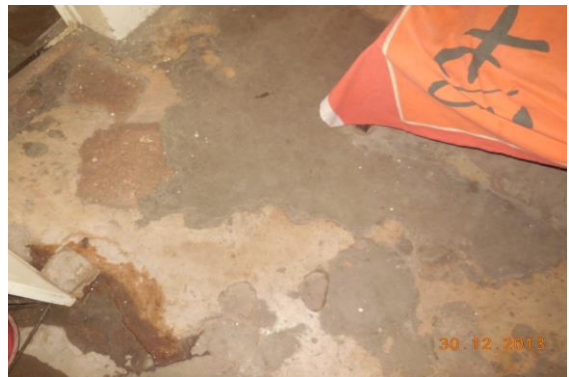
Photo 4  
Peeling of Plaster on Floor of Room No. 1 of House No. 2463, First Floor

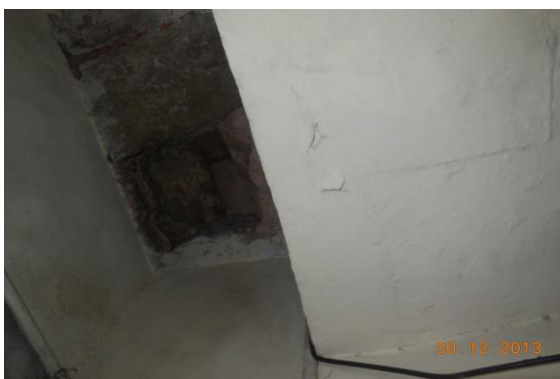
Photo 5  
Peeling of Plaster on Roof of Toilet No. 1 of House No. 2463, First Floor

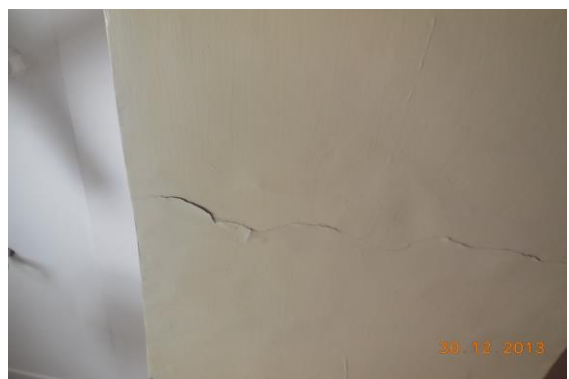
Photo 6  
Peeling of Plaster on Wall No. 3 of Varanda No. 2 of House No. 2463, First Floor

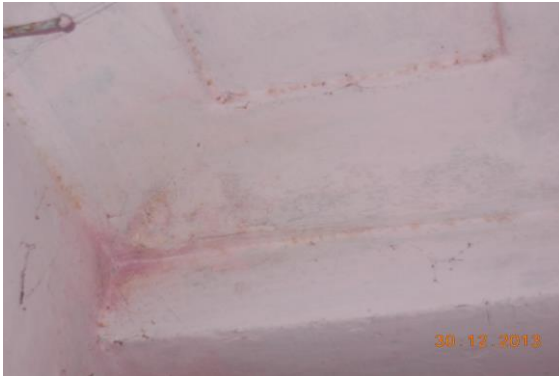
Photo 7

Dampness/Seepage on Wall No. 1, 2 & Roof of Varanda 1 of House No. 2463, Second Floor

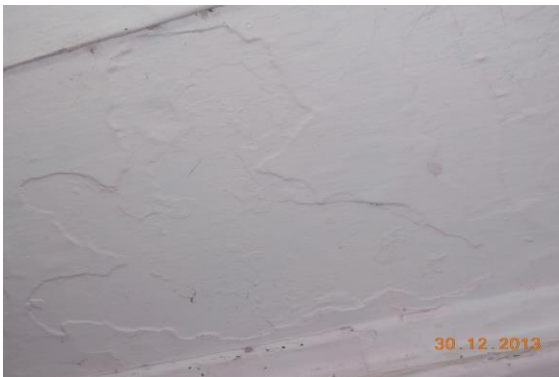
Photo 9

Peeling of Plaster on Roof of Room No. 1 of House No. 2463, Second Floor

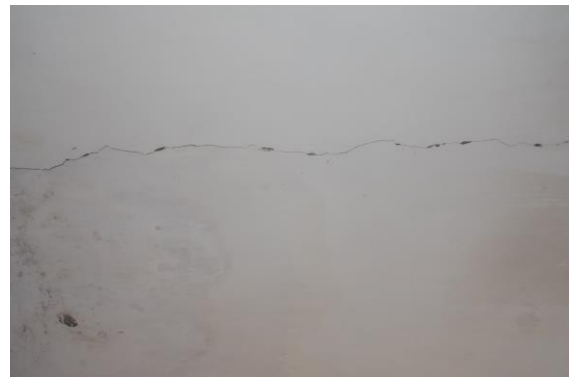
Summary of Cracks						
Defect ID	Location	Orientation	Appx. Width (mm)	Appx. Length (m)	Category	Photo No.
1	Roof Varanda of shop No.326 Ground Floor	Horizontal	1.5	2	Slight	4
2	Wall No. 4 Toilet No. 1 House No. 2462 First Floor	Inclined	0.4	2.6	Very Slight	5, 5A

Photo 4  
Horizontal Crack on Roof of Varanda of shop No.326, Ground Floor  
Approx. Width = 1.5mm, Approx. Length = 2m. Distance from Backside of L.S. Ext. column = 0m, Height from Floor = 3.5m.

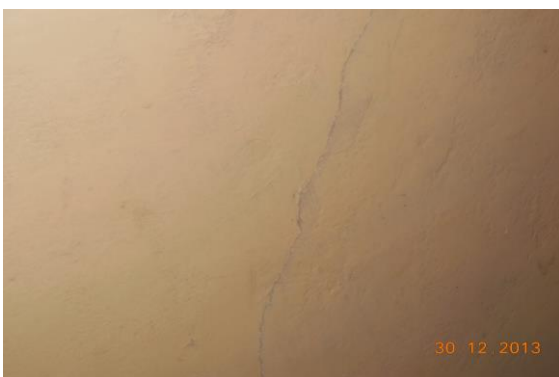
Photo 5  
Inclined Crack on Wall No. 4 of Toilet No. 1, House No. 2462 First Floor  
Approx. Width = 0.4mm, Approx. Length = 2.6m. Distance from Wall No.2 = 0.4m, Height from Floor = 0m.

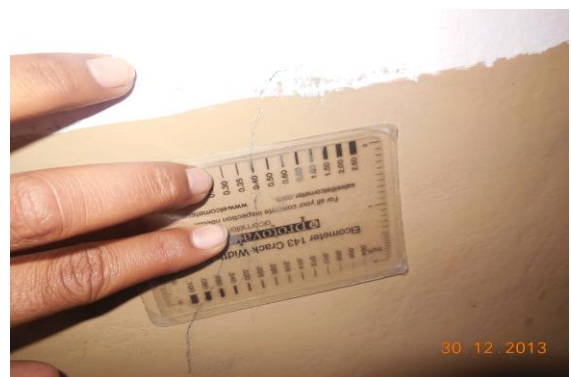
Photo 5A  
Inclined Crack on Wall No. 4 of Toilet No. 1, House No. 2462 First Floor  
Approx. Width = 0.4mm, Approx. Length = 2.6m. Distance from Wall No.2 = 0.4m, Height from Floor = 0m.

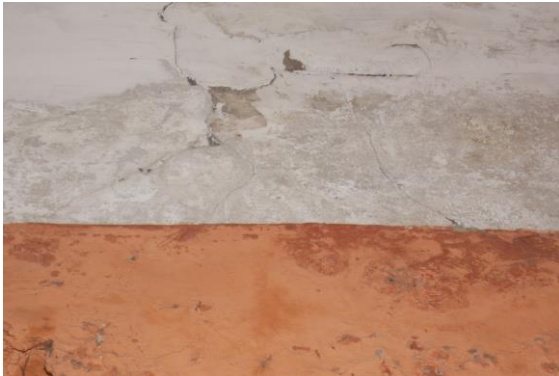
Photo 6

Peeling of Plaster on Leftside External Column of Varanda of shop No.326 of Ground Floor

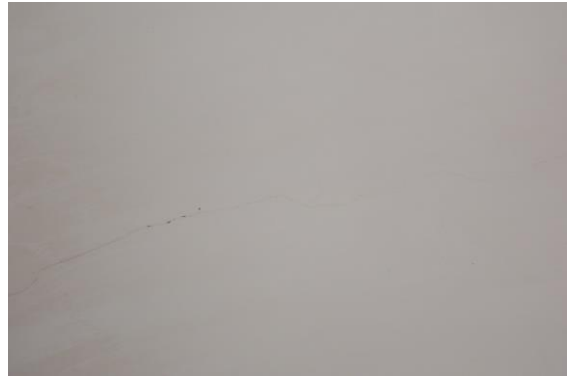
Photo 7

Peeling of Plaster on Roof of Varanda of shop No.326 of Ground Floor

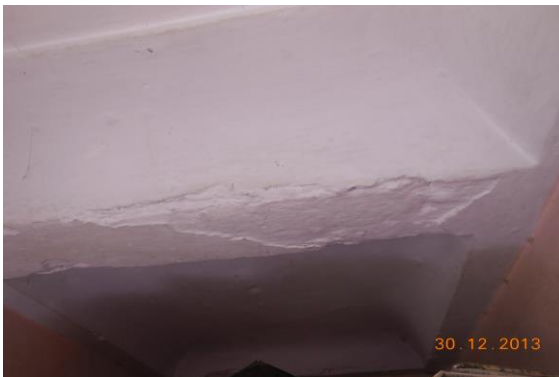
Photo 8

Peeling of Plaster on Wall No. 2 of Varanda 2 of House No. 2462 First Floor

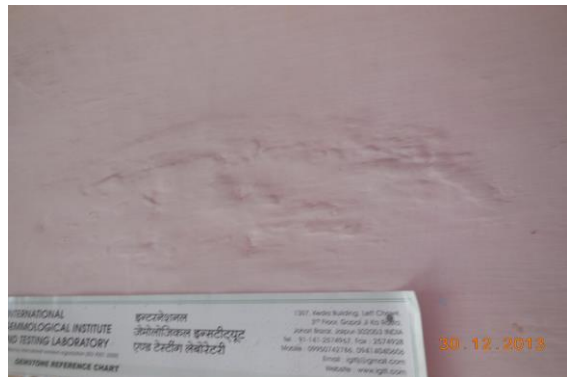
Photo 9

Peeling of Plaster on Wall No. 3 of Room No. 1 of House No. 2462 First Floor

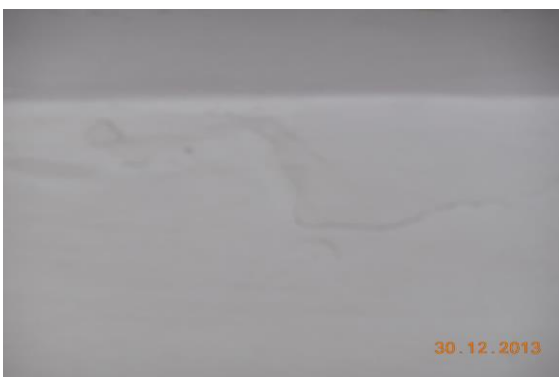
Photo 10

Peeling of Plaster on Wall No. 4 of Room No. 1 of House No. 2462 First Floor

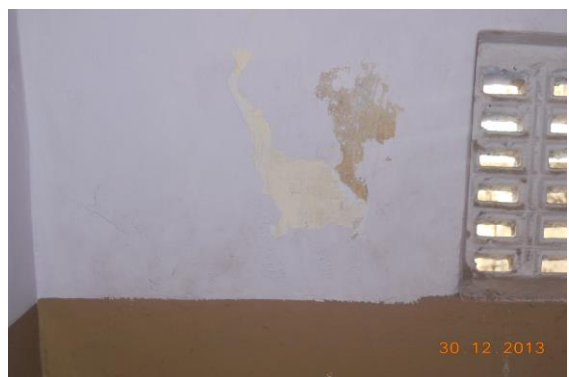
Photo 11

Peeling of Plaster on Wall No. 2 of Toilet No. 1 of House No. 2462 First Floor

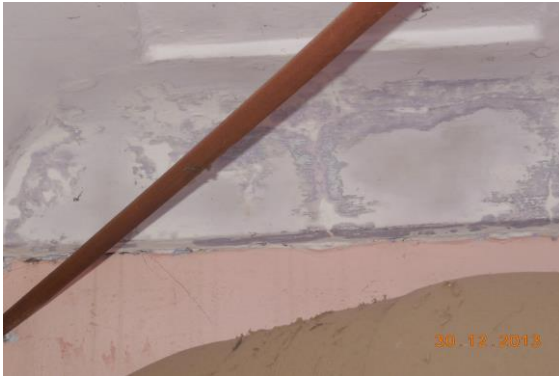
Photo 12

Dampness/Seepage on Wall No. 2 of Varanda 2 of House No. 2462 First Floor

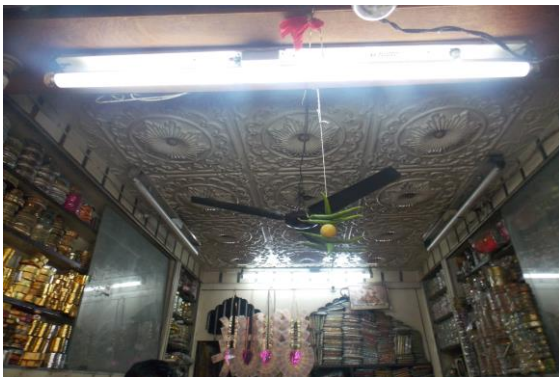
Photo 14

All Walls & Roof of Shop No.326 of Ground Floor Covered with Wooden Racks & Falls Ceiling

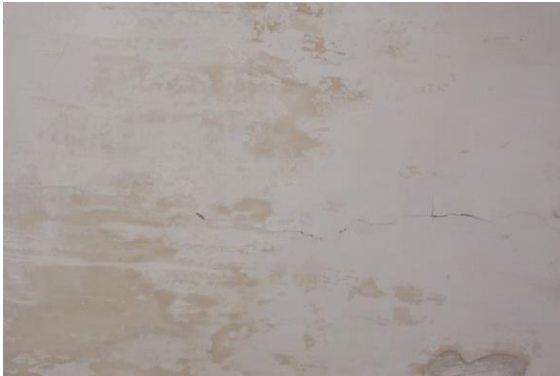
Photo 39  
Horizontal Crack on Roof of Varanda of Shop No.325, Ground Floor  
Approx. Width = 0.25mm, Approx. Length = 1.8m. Distance Backside of  
Rightside external column = 1m, Height Floor = 3.5m.

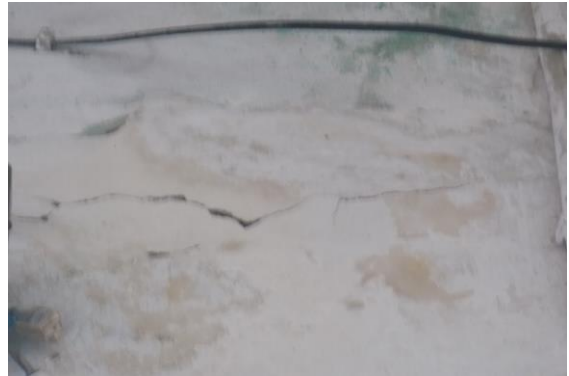
Photo 40  
Horizontal Crack on Beam of Varanda of shop no.324, Ground Floor  
Approx. Width = 0.5mm, Approx. Length = 1.3m. Distance Backside of  
Leftside external column = 0m, Height Floor = 3.3m.

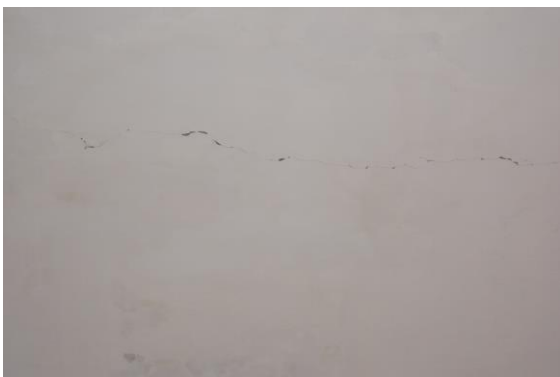
Photo 41  
Horizontal Crack on Roof of Varanda of Shop No.321, Ground Floor  
Approx. Width = 0.35mm, Approx. Length = 2m. Distance from Leftside  
External column = 0.8m, Height from Floor = 3.5m.

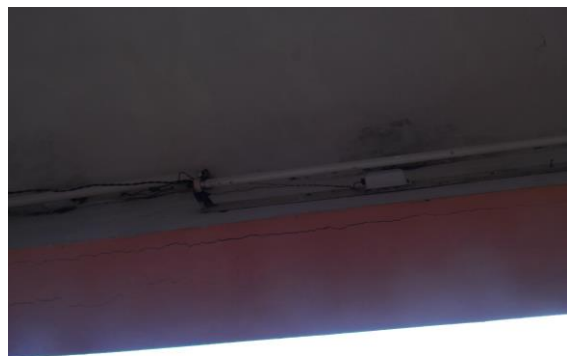
Photo 42  
Horizontal Crack on Beam of Varanda of Shop No.321, Ground Floor  
Approx. Width = 1mm, Approx. Length = 2.5m. Distance from Leftside  
External column = 0.3m, Height from Floor = 3m.

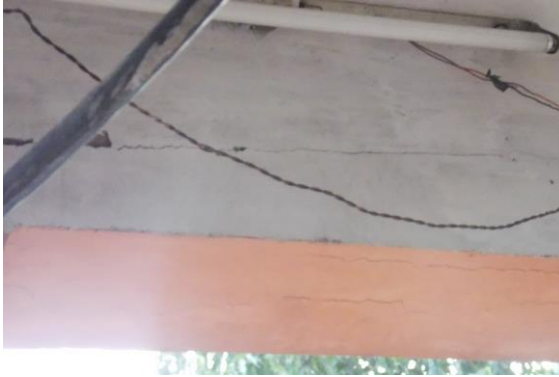
Photo 43

Horizontal Crack on External Beam of Varanda of Shop No.321, Ground Floor Approx. Width = 1mm, Approx. Length = 1.5m. Height from Floor = 3.3m.

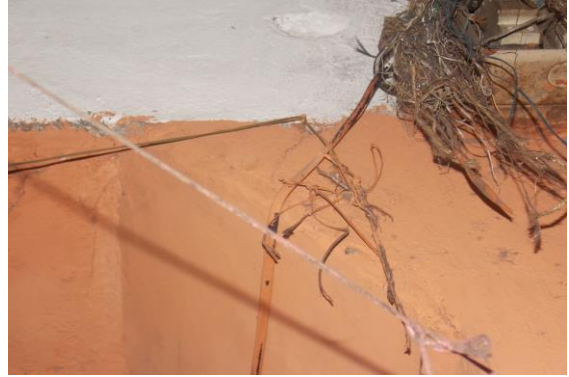
Photo 44

Inclined Crack on Leftside External Column of Varanda Of Shop, Ground Floor Approx. Width = 0.5mm, Approx. Length = 0.4m. Distance Backside Leftside external col = 0m, Height Floor = 3m.

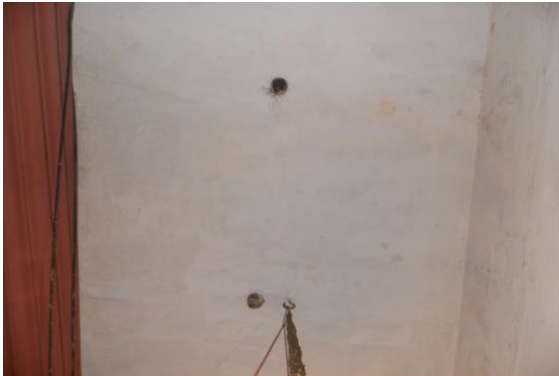
Photo 45

Horizontal Crack on Roof of Varanda of Shop, Ground Floor Approx. Width = 0.4mm, Approx. Length = 1.5m. Distance Backside of Leftside external column = 0m, Height Floor = 3.5m.

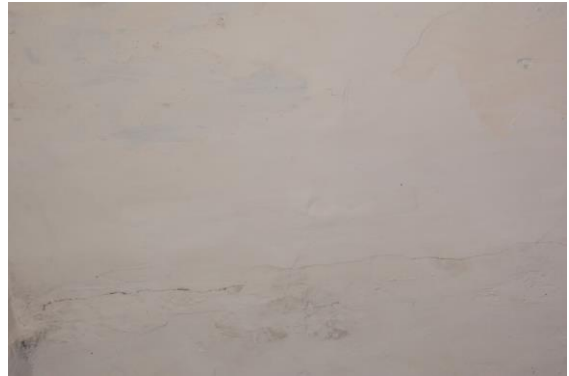
Photo 45A

Horizontal Crack on Roof of Varanda of Shop, Ground Floor Approx. Width = 0.4mm, Approx. Length = 1.5m. Distance Backside of Leftside external column = 0m, Height Floor = 3.5m.

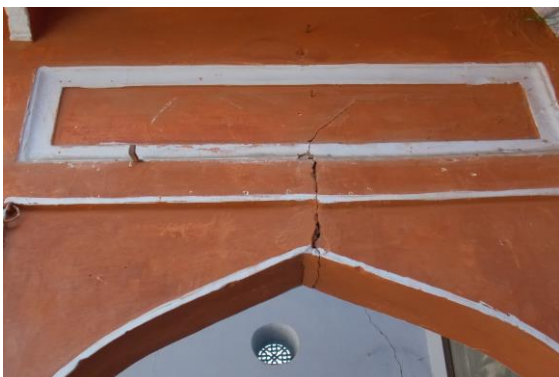
Photo 46

Inclined Crack on Wall No. 4 of Open Sky, Part A, House No. 2144, First Floor Approx. Width = 1mm, Approx. Length = 0.8m. Distance from Wall No.2 = 0m, Height from Floor = 2.2m.

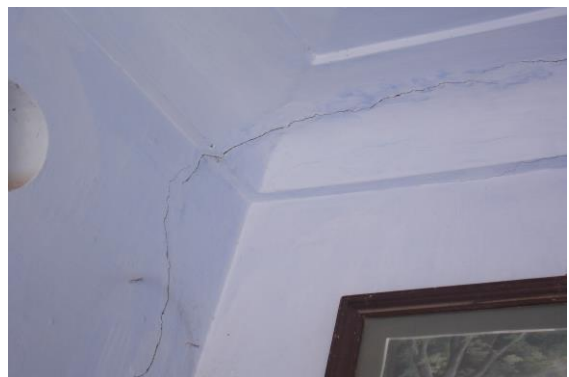
Photo 47

Inclined Crack on Wall No. 4 of Varanda 7, Part A, House No. 2144, First Floor Approx. Width = 0.8mm, Approx. Length = 4m. Distance from Wall No.4 = 0m, Height from Floor = 0m.

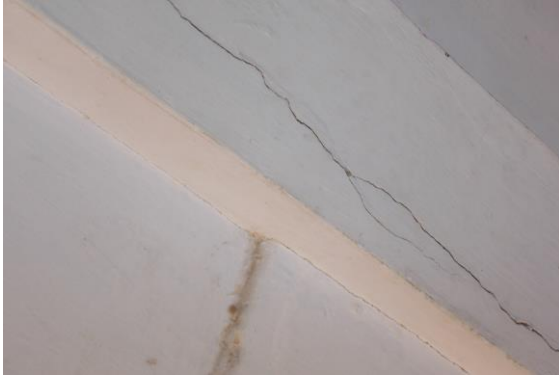
Photo 47A

Inclined Crack on Wall No. 4 of Varanda 7, Part A, House No. 2144, First Floor Approx. Width = 0.8mm, Approx. Length = 4m. Distance from Wall No.4 = 0m, Height from Floor = 0m.

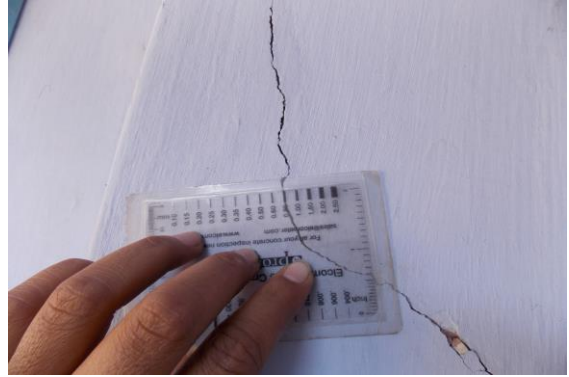
Photo 47A

Inclined Crack on Wall No. 4 of Varanda 7, Part A, House No. 2144, First Floor Approx. Width = 0.8mm, Approx. Length = 4m. Distance from Wall No.4 = 0m, Height from Floor = 0m.

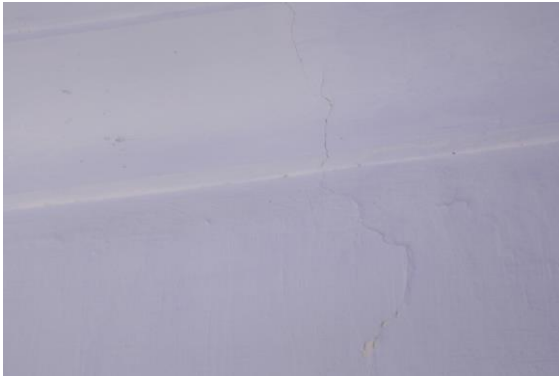
Photo 48

Inclined Crack on Wall No. 4 of Varanda 7, Part A, House No. 2144, First Floor Approx. Width = 0.2mm, Approx. Length = 1m. Distance from Wall No.4 = 2.5m, Height from Floor = 2.5m.

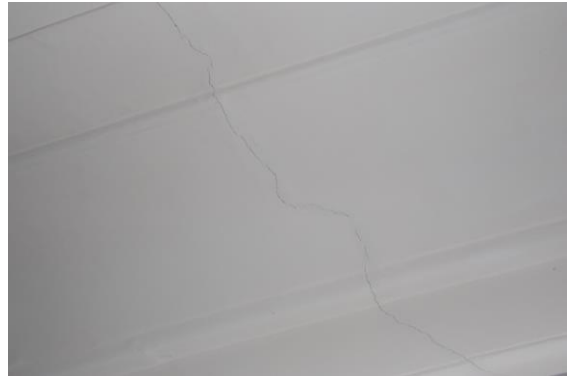
Photo 49

Inclined Crack on Wall No. 4 & Roof of Hall No. 1, Part 1, House No. 2144, First Floor Approx. Width = 0.2mm, Approx. Length = 1.5m. Distance from Wall No.2 = 1m, Height from Floor = 2.8m.

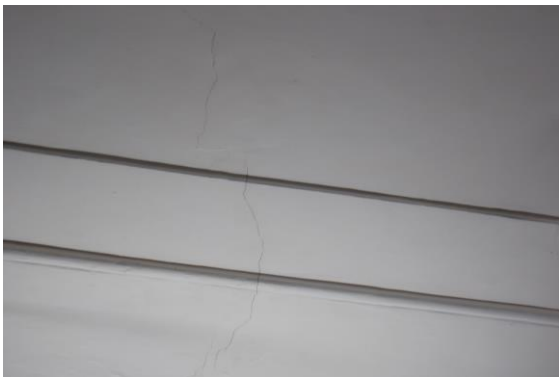
Photo 50

Inclined Crack on Wall No. 3 of Hall No. 1, Part 2, House No. 2144, First Floor Approx. Width = 0.15mm, Approx. Length = 1m. Distance from Wall No.2 = 0m, Height from Floor = 2.8m.

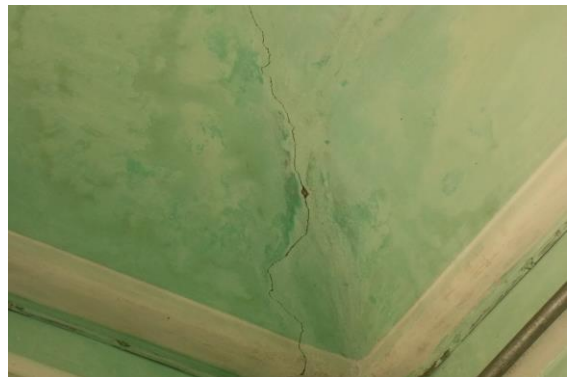
Photo 51

Horizontal Crack on Wall No. 3 & Roof of Varanda 1, Part A, House No. 2144, First Floor Approx. Width = 0.25mm, Approx. Length = 0.65m. Distance Wall No.1 = 2.5m, Height Floor = 3m.

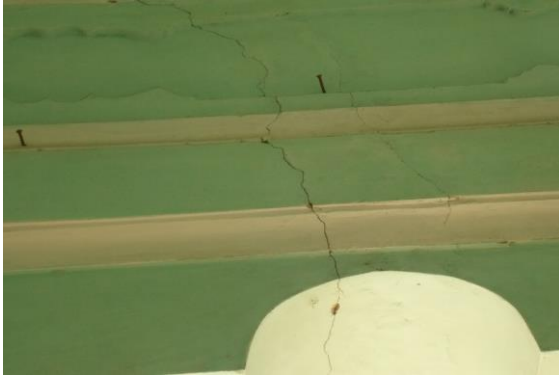
Photo 52

Inclined Crack on Wall No. 3 of Varanda 4, Part A, House No. 2144, First Floor Approx. Width = 0.6mm, Approx. Length = 1m. Distance from Wall No.1 = 1.2m, Height from Floor = 2.5m.

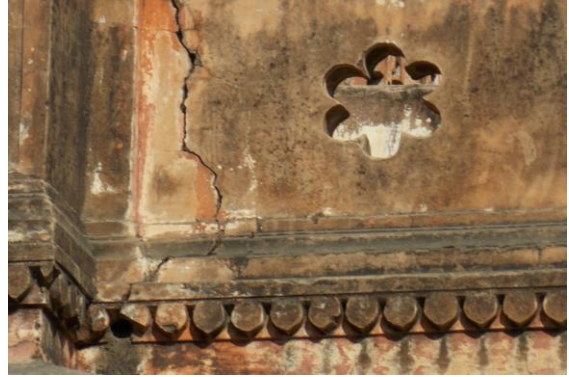
Photo 53

Inclined Crack on Wall No. 3 of External Parapit Wall, House No. 2144, First Floor Approx. Width = 5mm, Approx. Length = 1m. Distance from Wall No.1 = 5m, Height from Floor = 2.5m.

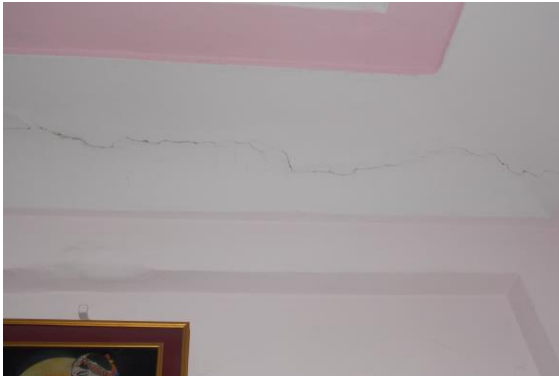
Photo 54

Horizontal Crack on Wall No. 1, 2 & Roof of Room No. 6, House No. 2144, First Floor Approx. Width = 1mm, Approx. Length = 3m. Distance from Wall No.4 = 0.2m, Height from Floor = 2m.

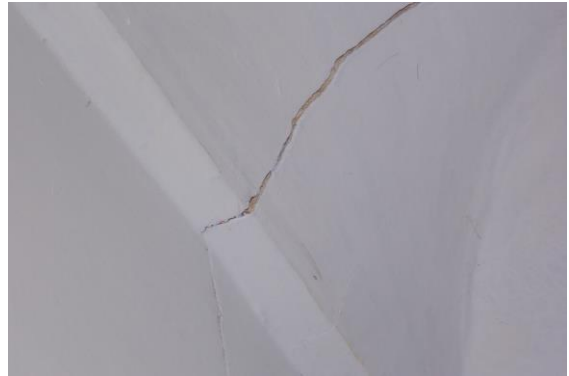
Photo 55

Inclined Crack on Wall No. 3 of Room No. 9, House No. 2144, First Floor Approx. Width = 2mm, Approx. Length = 2m. Distance from Wall No.1 = 0.3m, Height from Floor = 1.5m.

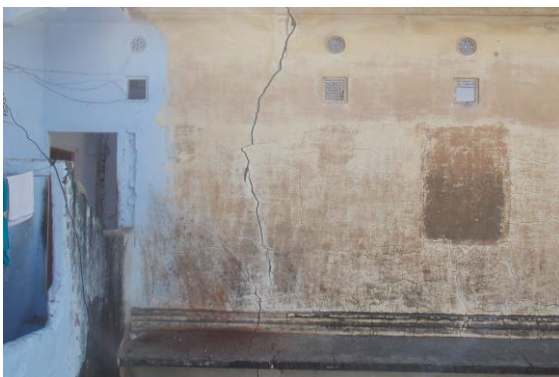
Photo 56

Inclined Crack on Wall No. 4 of Open Sky , Part B, House No. 2144, Second Floor Approx. Width = 20mm, Approx. Length = 8.5m. Distance Wall No.1 = 1m, Height Floor = 4.5m.

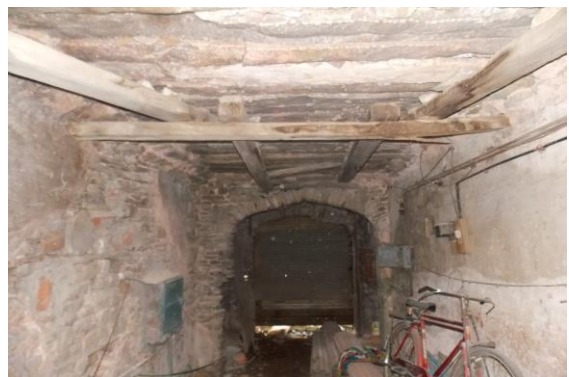
Photo 57

Inclined Crack on Wall No. 4 of Open Sky , Part B, House No. 2144, Second Floor Approx. Width = 5mm, Approx. Length = 3m. Distance Wall No.1 = 7m, Height Floor = 0m.

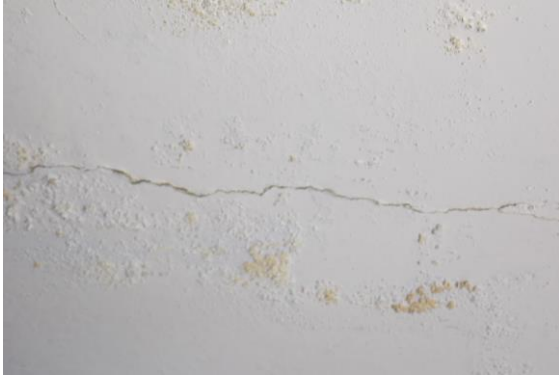
Photo 58

Inclined Crack on Roof of Bathroom, Part C, House No. 2144, Second Floor Approx. Width = 0.4mm, Approx. Length = 1.8m. Distance Wall No.2 = 0.2m, Height Floor = 2m.

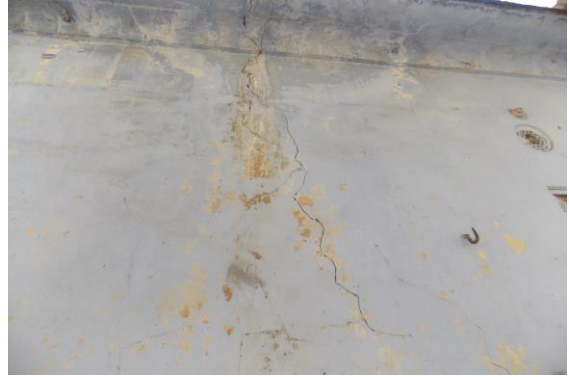
Photo 59

Inclined Crack on Wall No. 2 of Passage ,Part C, House No. 2144, Second Floor Approx. Width = 5mm, Approx. Length = 2.5m. Distance Wall No.3 = 3m, Height Floor = 1m.

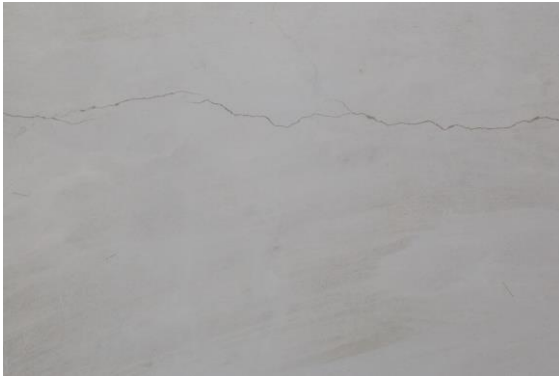
Photo 60

Inclined Crack on Roof of Hall No. 4, House No. 2144, Second Floor, Passage ,Part C Approx. Width = 0.5mm, Approx. Length = 2.5m. Distance Wall No.3 = 2.5m, Height Floor = 3.5m.

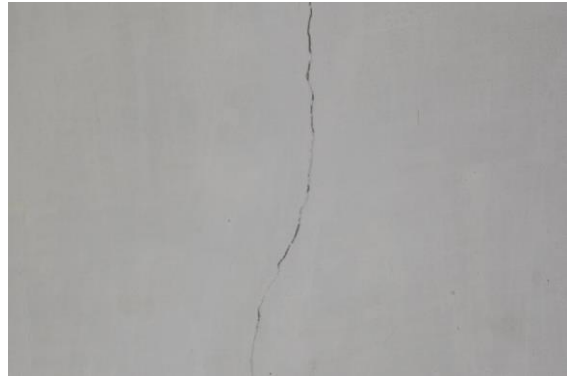
Photo 61

Inclined Crack on Wall No. 2 of Room No. 3, Open Sky, Part B, Part 3, House No. 2144, First Floor Approx. Width = 1.5mm, Approx. Length = 2m. Distance Wall No.3 = 1.2m, Height Floor = 0m.

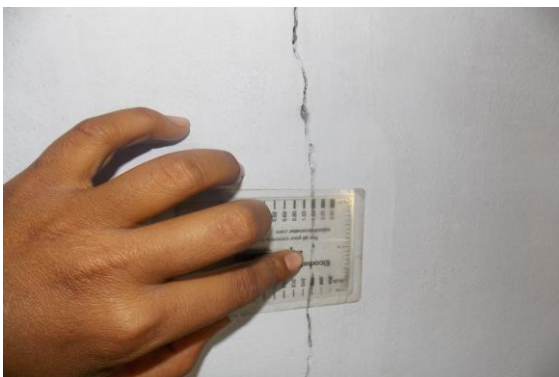
Photo 61A

Inclined Crack on Wall No. 2 of Room No. 3, Open Sky, Part B, Part 3, House No. 2144, First Floor Approx. Width = 1.5mm, Approx. Length = 2m. Distance from Wall No.3 = 1.2m, Height Floor = 0m.

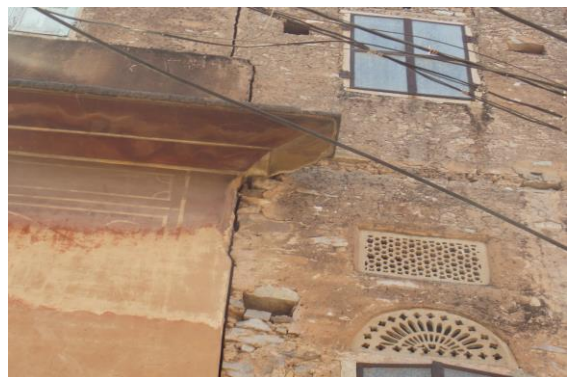
Photo 62

Vertical Crack on External Wall of FF to SF, House No. 2144 Approx. Width = 25mm, Approx. Length = 4m. Distance from Front Side Wall = 2.8m, Height from Floor = 2m.

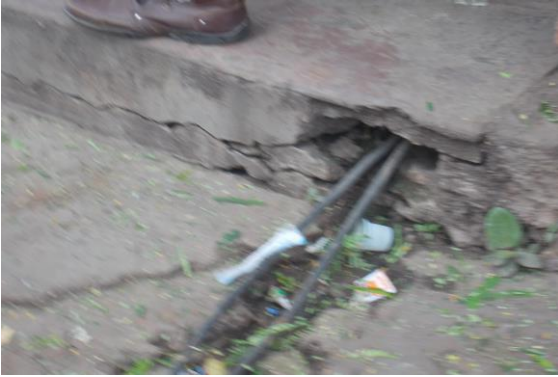
Photo 63

Peeling of Plaster on Floor of Varanda of Shop No.325 of Ground Floor

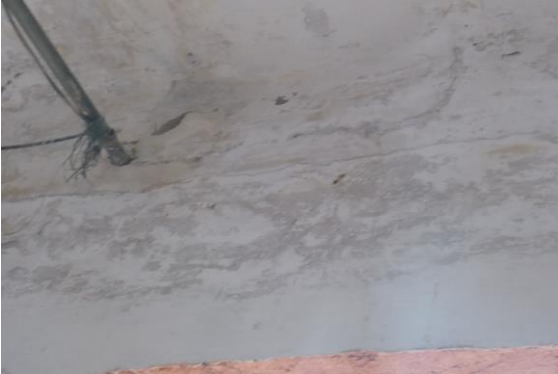
Photo 65

Peeling of Plaster on External Beam of Varanda of Shop No.325 of Ground Floor

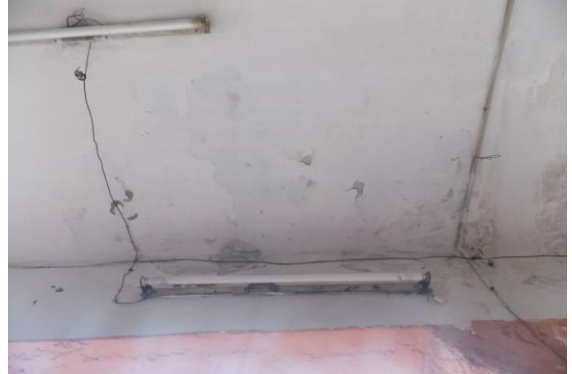
Photo 66

Dampness/Seepage on Roof & External Beam of Varanda of shop no.324 of Ground Floor

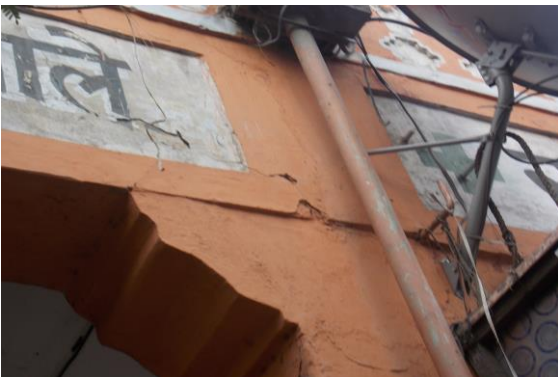
Photo 67

Peeling of Plaster on Rightside External Column & Outer Wall of Varanda of shop no.324 of Ground Floor

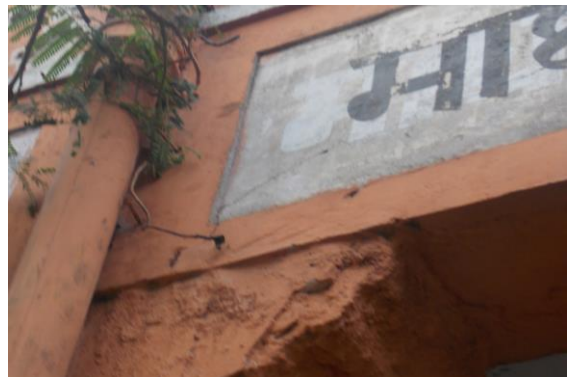
Photo 68

Peeling of Plaster on Roof of of Ground Floor

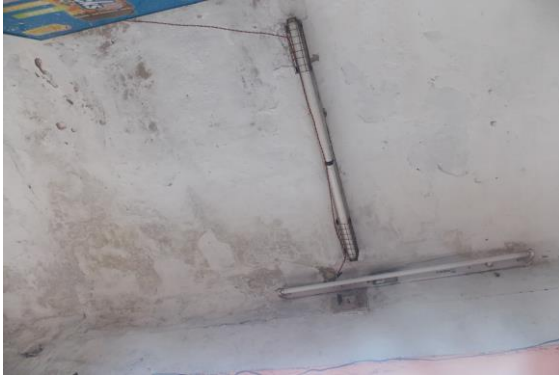
Photo 69

Dampness/Seepage on Roof of Varanda of Shop No.323 of Ground Floor

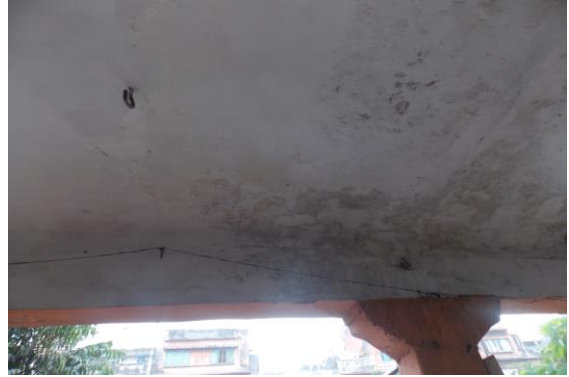
Photo 70

Dampness/Seepage on Roof of Varanda of Shop No.322 of Ground Floor

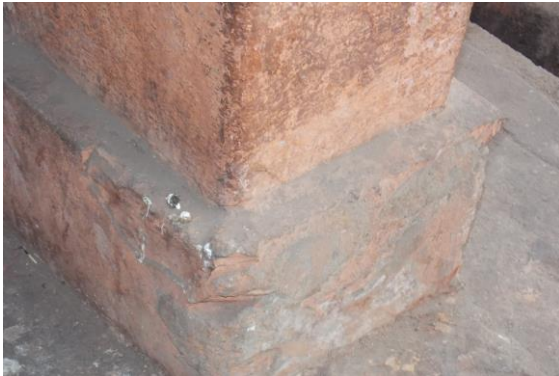
Photo 71

Peeling of Plaster on Rightside External Column of Varanda of Shop No.322 of Ground Floor

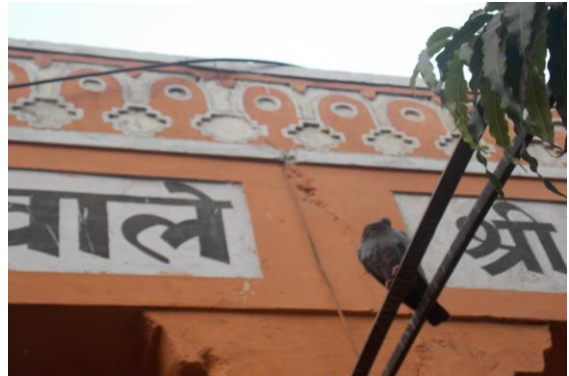
Photo 72

Peeling of Plaster on Beam of Varanda of Shop No.322 of Ground Floor

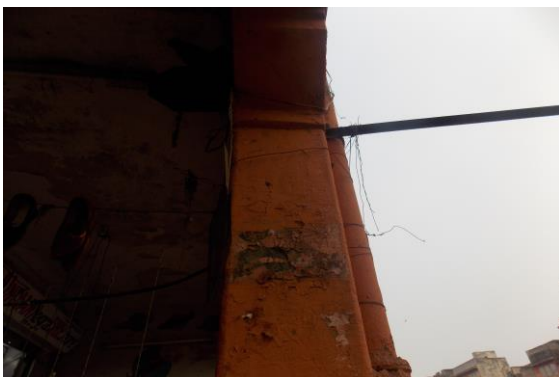
Photo 73

Peeling of Plaster on Rightside External Column of Varanda of Shop No.321 of Ground Floor

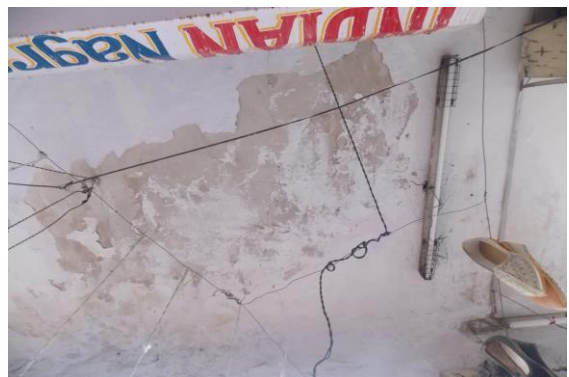
Photo 74

Dampness/Seepage on Roof of Varanda of shop No.320 of Ground Floor

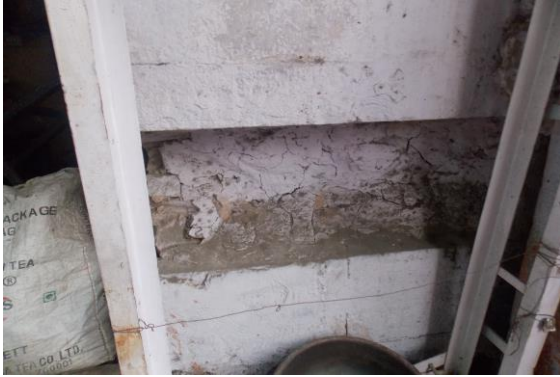
Photo 75

Peeling of Plaster on Rightside Wall of Varanda of Shop No.320A of Ground Floor

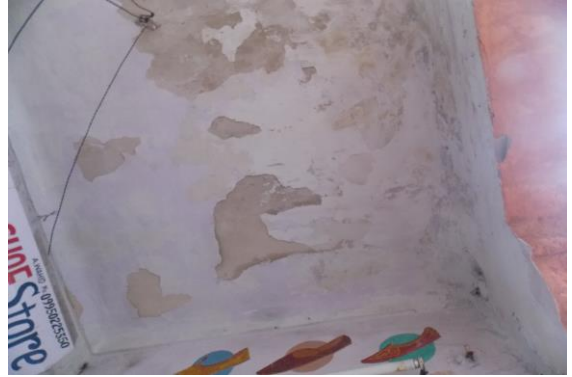
Photo 76

Dampness/Seepage on Roof of Varanda of Shop No.320A of Ground Floor

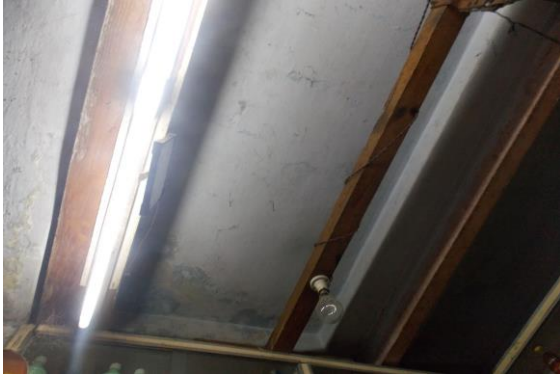
Photo 77

Dampness/Seepage on Roof of Shop No.319 of Ground Floor

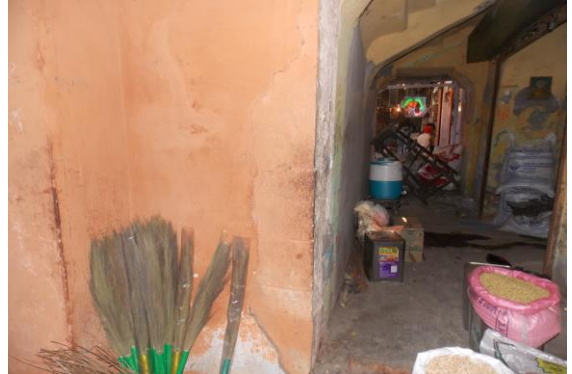
Photo 78

Peeling of Plaster on Leftside External Column of Varanda of Shop No.319 of Ground Floor

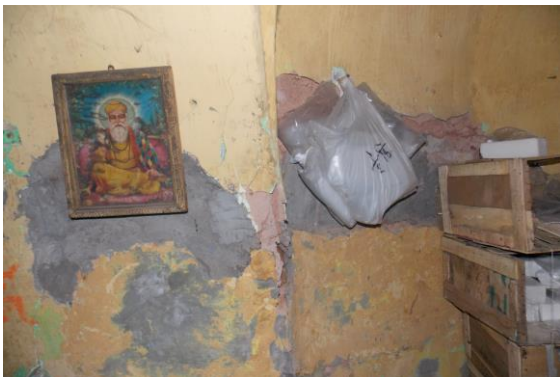
Photo 79

Peeling of Plaster on Wall No. 1 & Godown of Part b Of shop of Ground Floor

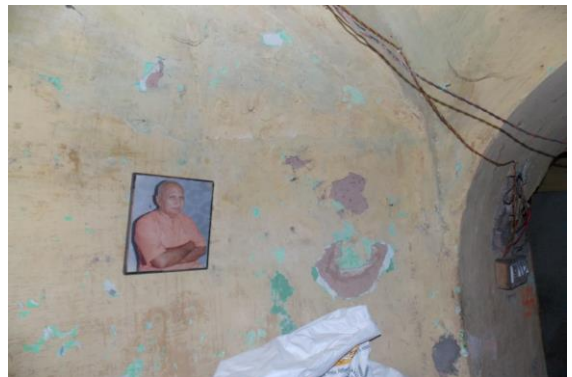
Photo 80

Peeling of Plaster on Wall No. 2 & Godown of Part b Of shop of Ground Floor

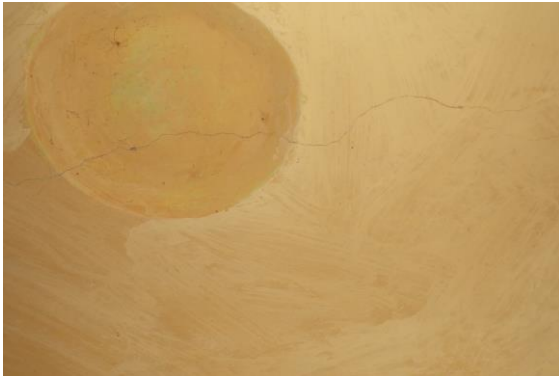
Photo 81

Peeling of Plaster on Roof & Godown of Part b Of shop of Ground Floor

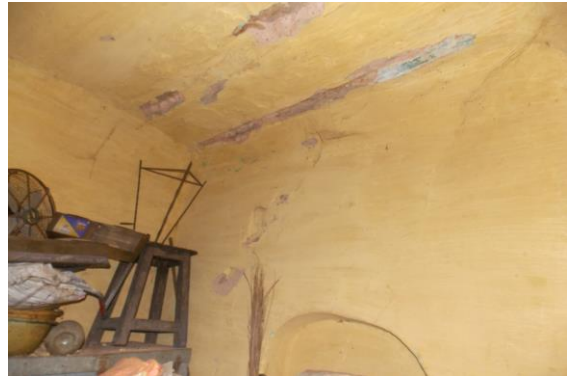
Photo 82

Peeling of Plaster on Wall No. 2, Roof & Godown of Part b Of shop of Ground Floor

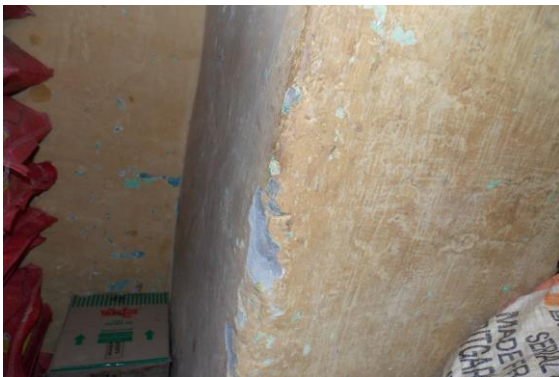
Photo 83

Peeling of Plaster on Wall No. 3 & Godown of Part b Of shop of Ground Floor

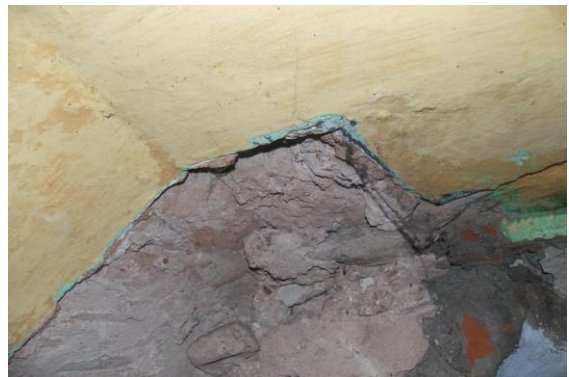
Photo 84

Peeling of Plaster on Right side Wall of Godown of Roof of Ground Floor

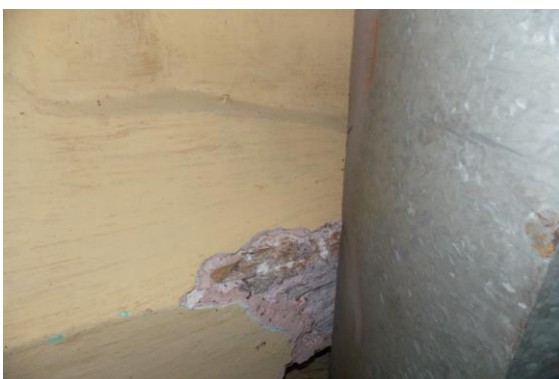
Photo 85

Peeling of Plaster on Roof of Varanda of shop of Ground Floor

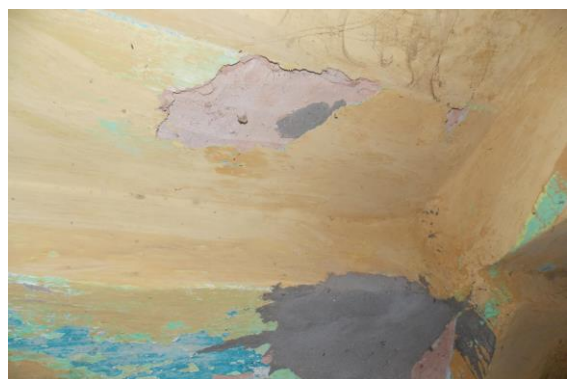
Photo 86

Peeling of Plaster on Roof of Varanda of shop of Ground Floor

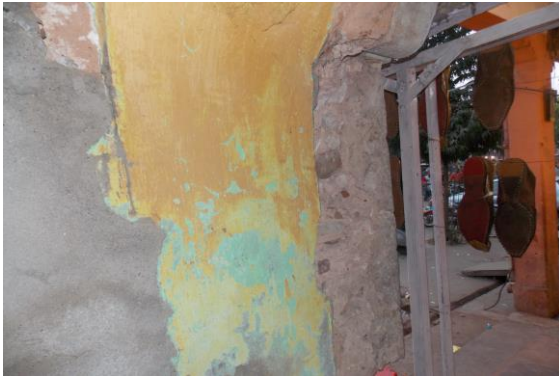
Photo 87

Peeling of Plaster on Wall No. 1 of Varanda of Shop of Ground Floor

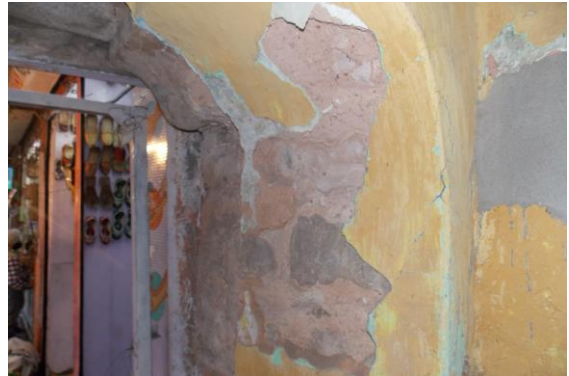
Photo 88

Peeling of Plaster on Wall No. 2 of Varanda of Shop of Ground Floor

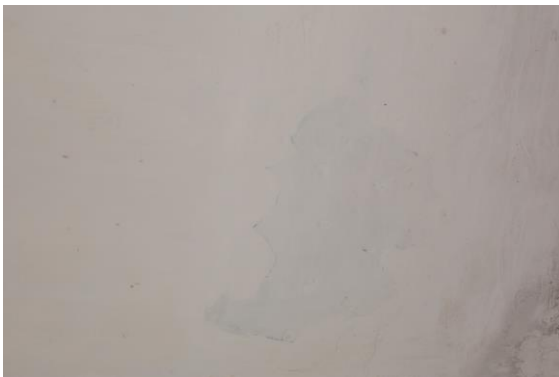
Photo 89

Peeling of Plaster on Roof of Varanda of Shop of Ground Floor

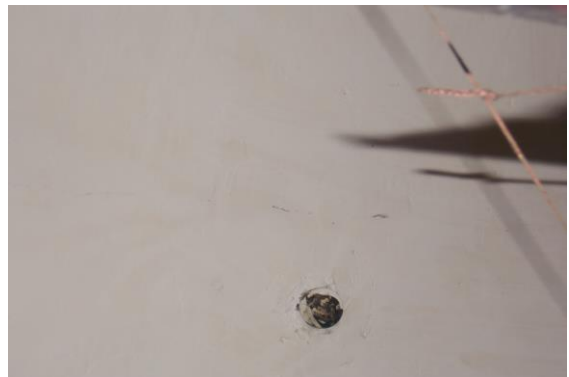
Photo 90

Peeling of Plaster on Roof of Varanda Of Shop of Ground Floor

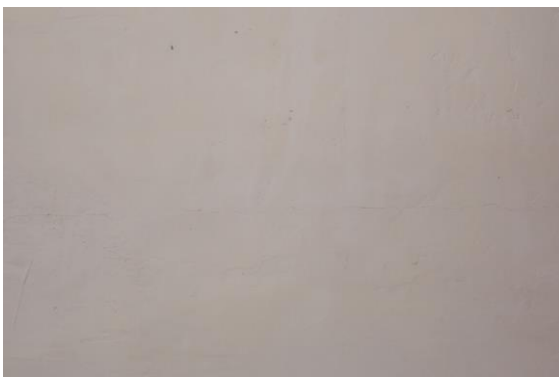
Photo 91

Peeling of Plaster on Roof of Varanda Of Shop of Ground Floor

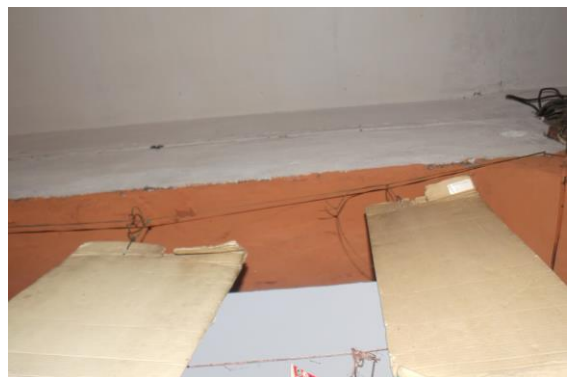
Photo 92

Peeling of Plaster on External Beam of Varanda of shop of Ground Floor

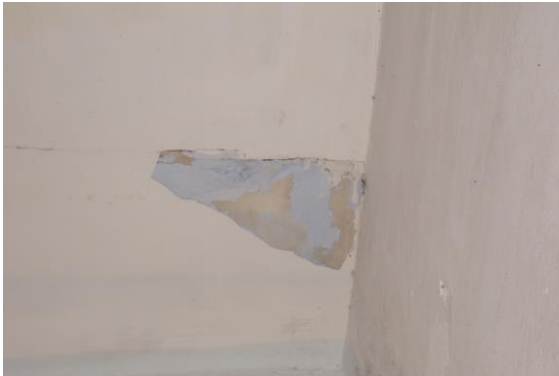
Photo 93

Peeling of Plaster on Roof of Varanda of shop of Ground Floor

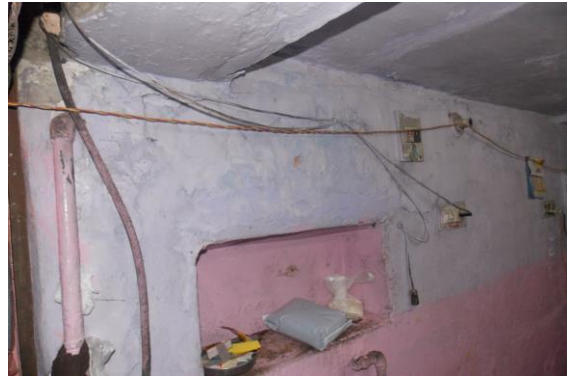
Photo 94

Peeling of Plaster on Wall No. 1 of Part A of shop of Ground Floor
