### Pre Building Condition Survey Report

Name and Address of Structure :	Badi Chopar to Ramp Area (UP Line)
---------------------------------	------------------------------------

Name of the Project	<b>Contract JMRC-UG1B</b> “Design and Construction of Tunnel between Chandpole and Badi Chouper and reverse line by Shield TBM, Underground Metro Stations at Choti Chouper and Badi Chouper by Cut and Cover Methods on East West Corridor of Jaipur Metro Rail Corporation Limited .”	
Owner :

Pre Building Condition Survey Report Badi Chopar to Ramp Area (UP Line)

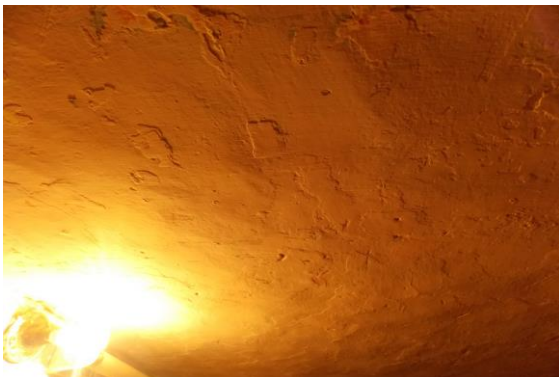
Photo 95

Peeling of Plaster on Roof of Part B of Shop of Ground Floor

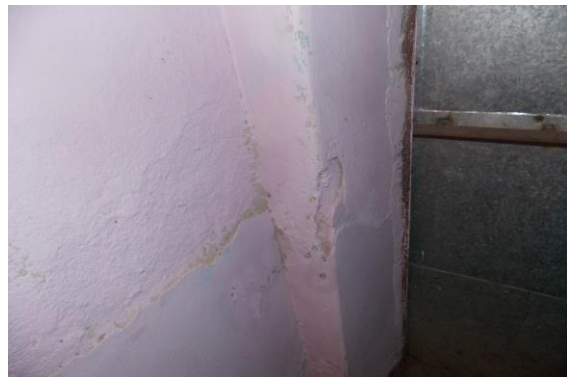
Photo 96

Peeling of Plaster on Wall No. 4 & 1 of Part B of Shop of Ground Floor

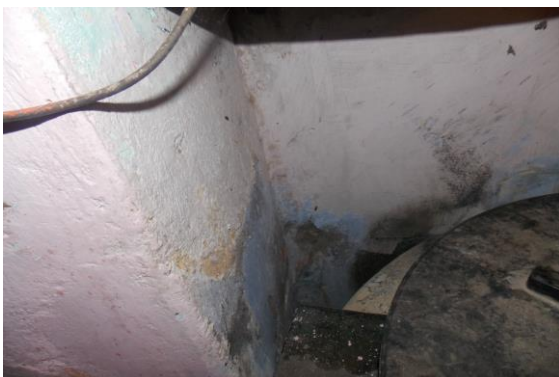
Photo 97

Peeling of Plaster on Wall No. 4 & 2 of Part B of Shop of Ground Floor

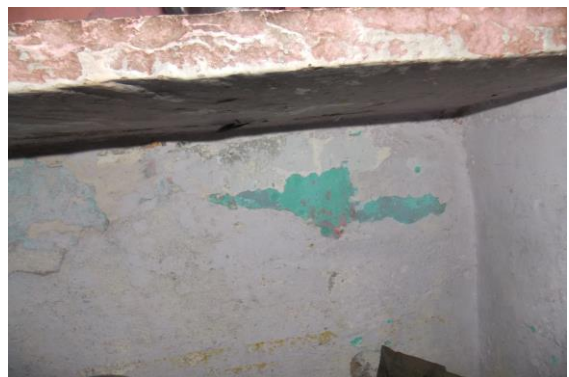
Photo 98

Peeling of Plaster on Wall No. 1 of Part B of Shop of Ground Floor

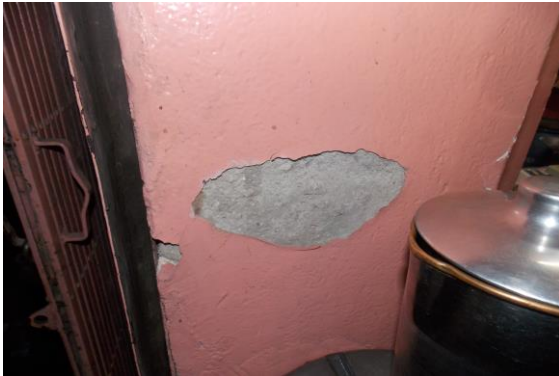
Photo 99

Peeling of Plaster on Wall No. 1 & Main Gate of Shop no.2 of Ground Floor

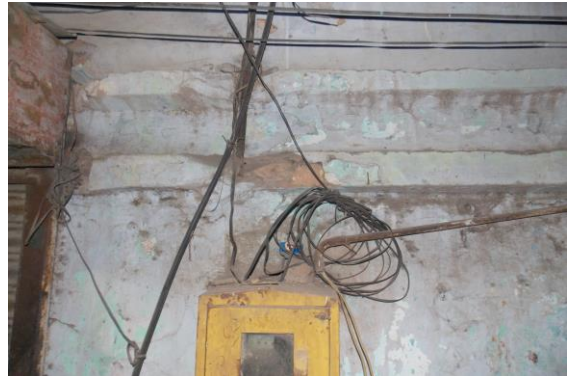
Photo 100

Peeling of Plaster on Outer Wall Left side Main door of Shop no.2 of Ground Floor

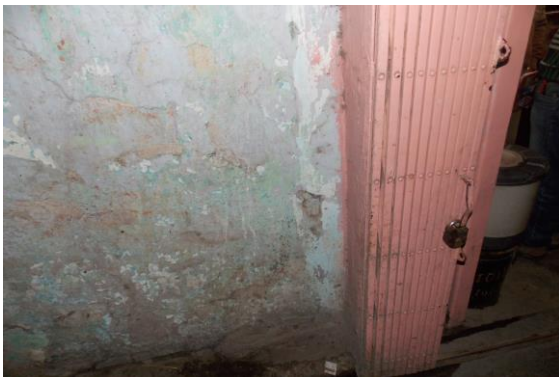
Photo 101

Peeling of Plaster on Outer Wall Left side Main door of Shop no.2 of Ground Floor

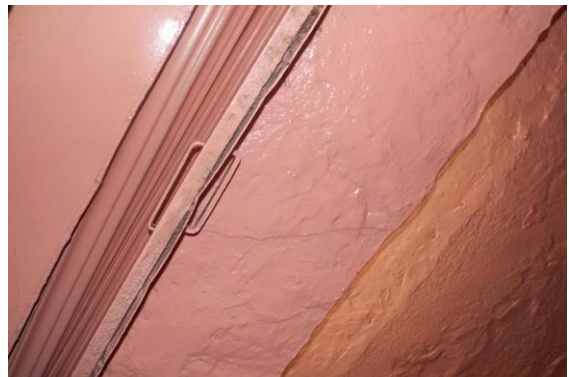
Photo 102

Peeling of Plaster on Main Gate Wall of shop No.4 of Ground Floor

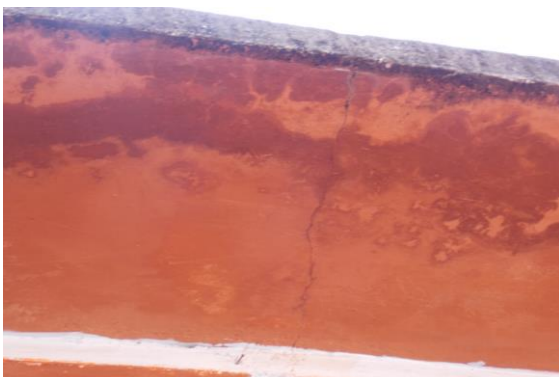
Photo 103

Plaster Crack on Wall No. 3 of Open Sky, Part A of House No. 2144, First Floor

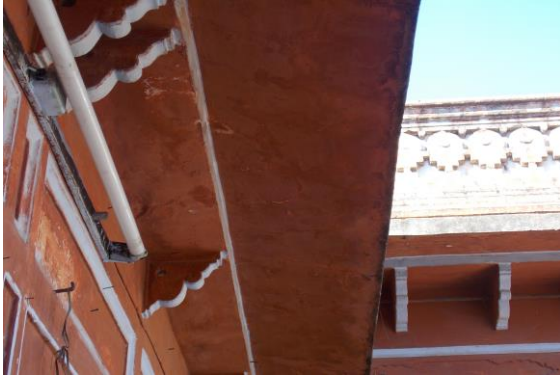
Photo 105

Plaster Crack on Wall No. 3 of Open Sky, Part A of House No. 2144, First Floor

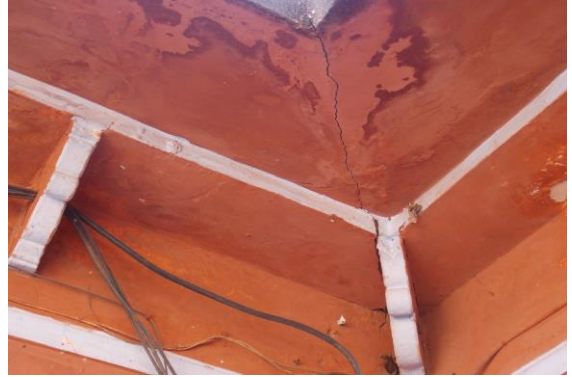
Photo 106

Peeling of Plaster on Wall No. 2, 3 & Shade of Open Sky, Part A of House No. 2144, First Floor

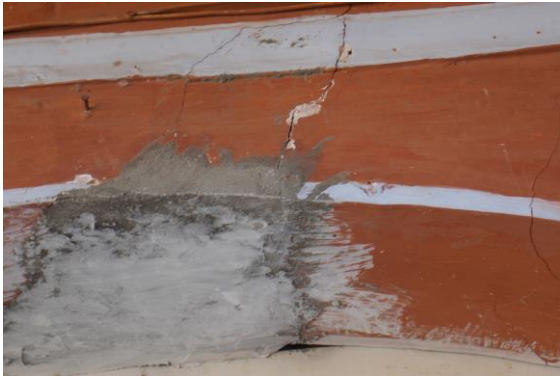
Photo 107

Peeling of Plaster on Wall No. 2 of Open Sky, Part A of House No. 2144, First Floor

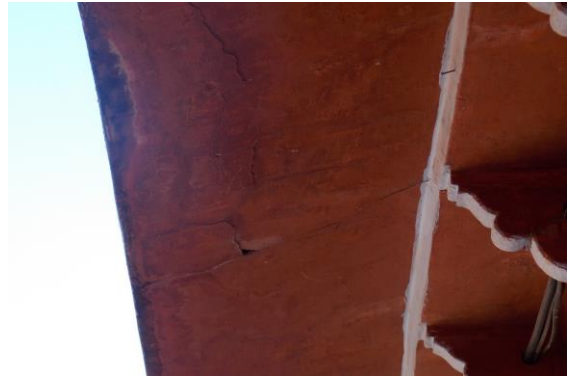
Photo 108

Peeling of Plaster on Wall No. 2 & Shade of Open Sky, Part A of House No. 2144, First Floor

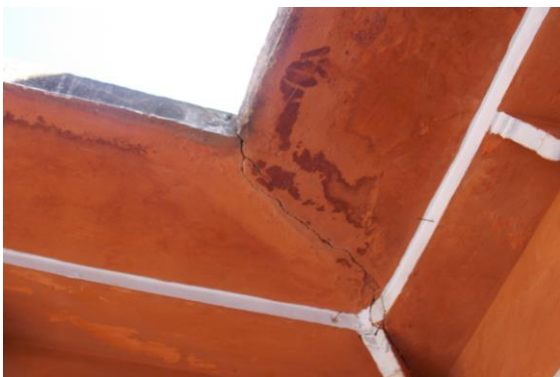
Photo 109

Peeling of Plaster on Wall No. 2 & 4 of Open Sky, Part A of House No. 2144, First Floor

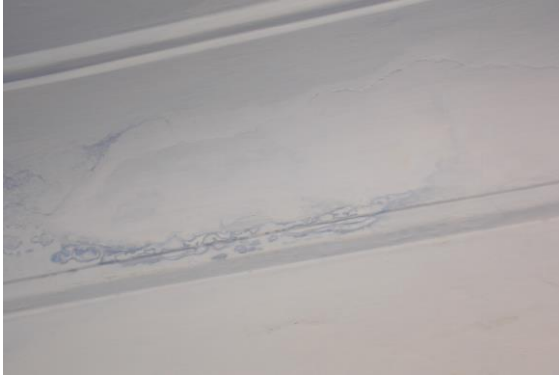
Photo 111

Dampness/Seepage on Roof of Varanda 8, Part A of House No. 2144, First Floor

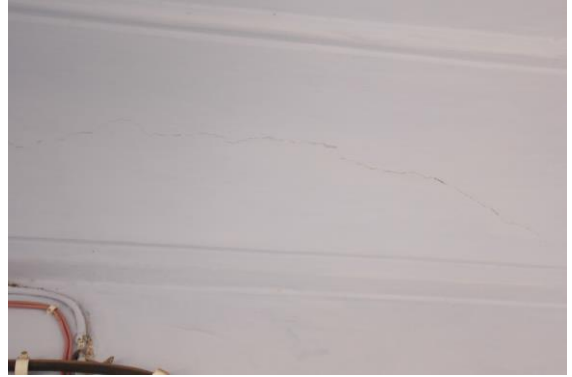
Photo 112

Dampness/Seepage on Roof of Varanda 8, Part A of House No. 2144, First Floor

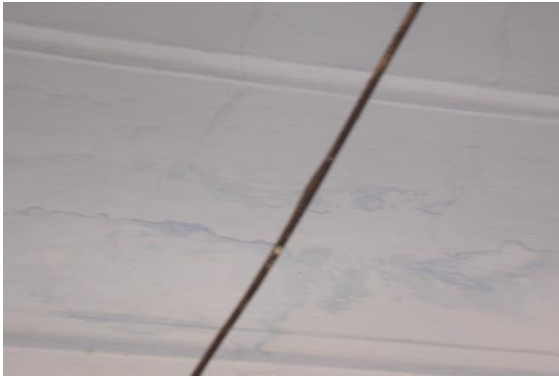
Photo 113

Dampness/Seepage on Roof of Varanda 8, Part A of House No. 2144, First Floor

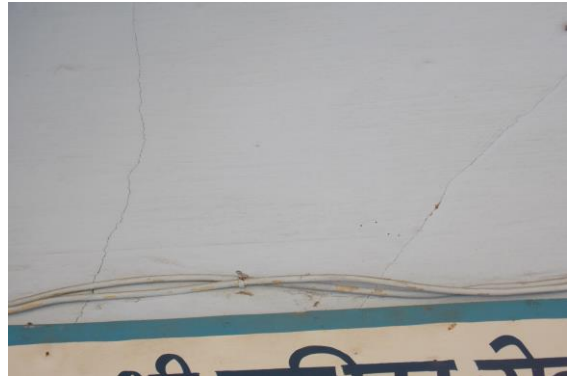
Photo 114

Plaster Crack on Wall No. 4 of Varanda 8, Part A of House No. 2144, First Floor

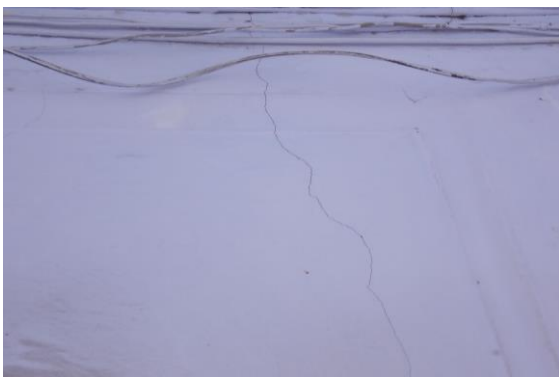
Photo 115

Plaster Crack on Wall No. 3 of Varanda 8, Part A of House No. 2144, First Floor

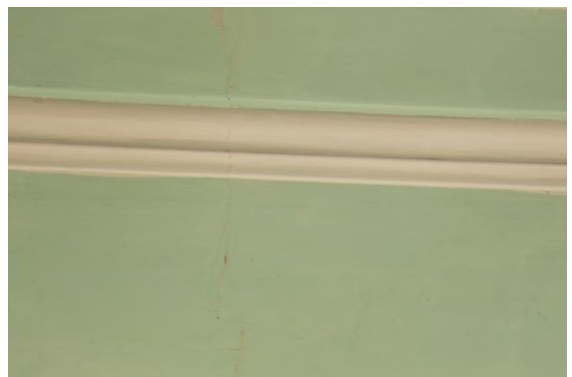
Photo 116

Plaster Crack on Roof of Varanda 1, Part A of House No. 2144, First Floor

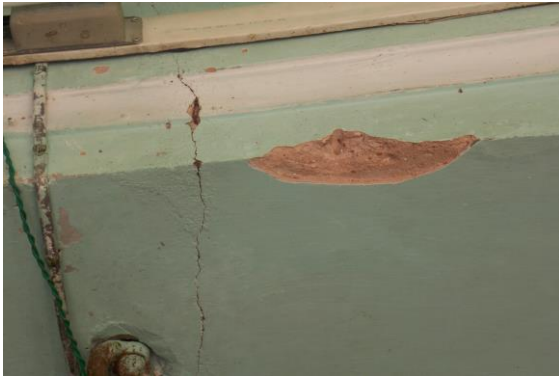
Photo 117

Peeling of Plaster on Roof of Varanda 1, Part A of House No. 2144, First Floor

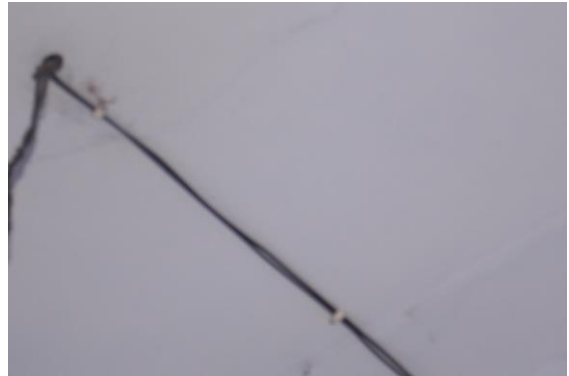
Photo 118

Plaster Crack on Roof of Varanda 4, Part A of House No. 2144, First Floor

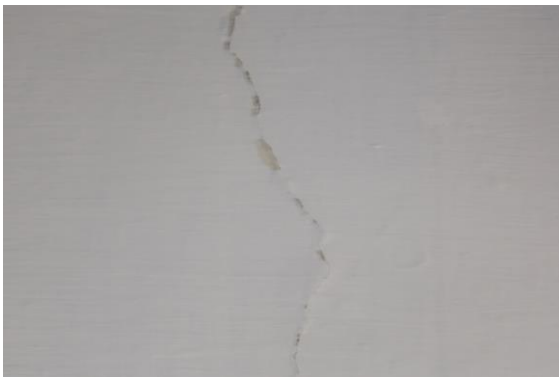
Photo 119

Plaster Crack on Wall No. 4 of Varanda 4, Part A of House No. 2144, First Floor

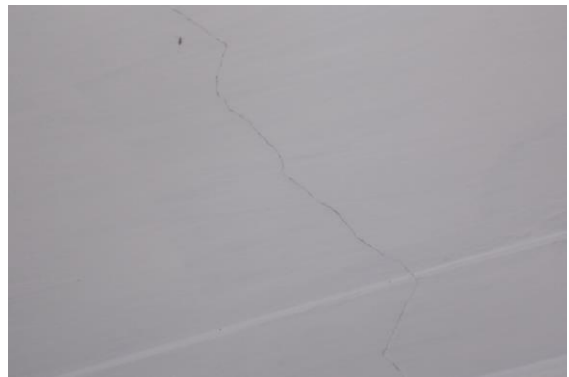
Photo 120

Plaster Crack on Roof of House No. 2144, First Floor, Varanda 4, Part A

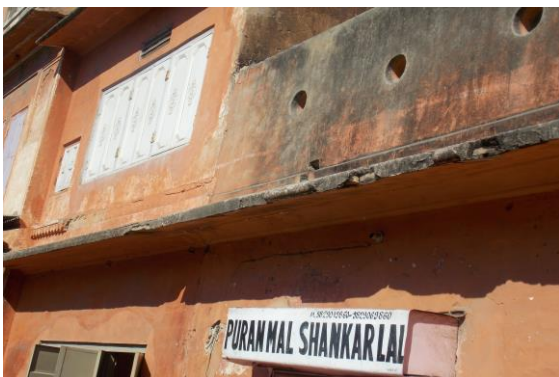
Photo 121

Damaged Portion on Wall No. 3 & Sunshade of Front Wall Shade of House No. 2144, First Floor

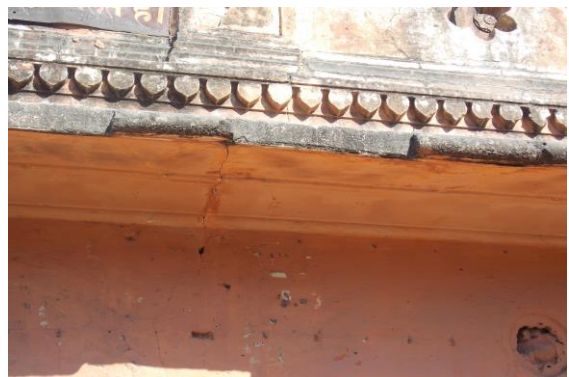
Photo 122

Damaged Portion on Wall No. 3 & Sunshade of Front Wall Shade of House No. 2144, First Floor

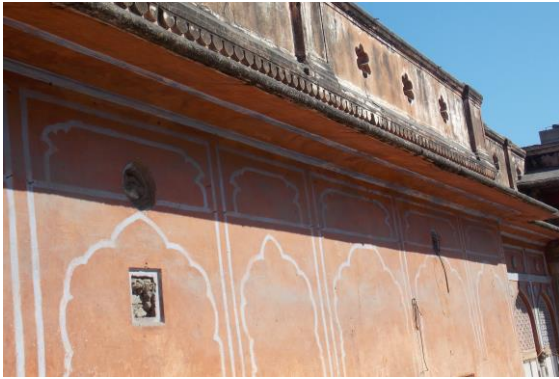
Photo 123

Damaged Portion on Wall No. 3 & Sunshade of Front Wall Shade of House No. 2144, First Floor

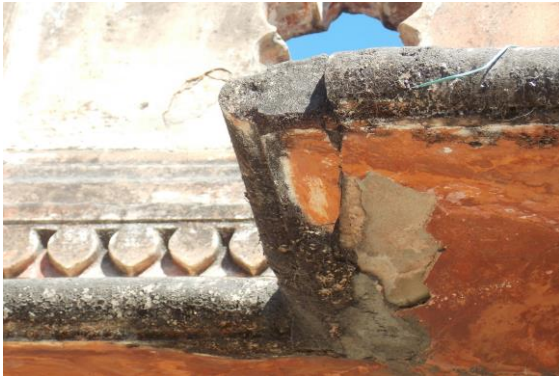
Photo 125

Damaged Portion on Wall No. 3 & Sunshade of Front Wall Shade of House No. 2144, First Floor

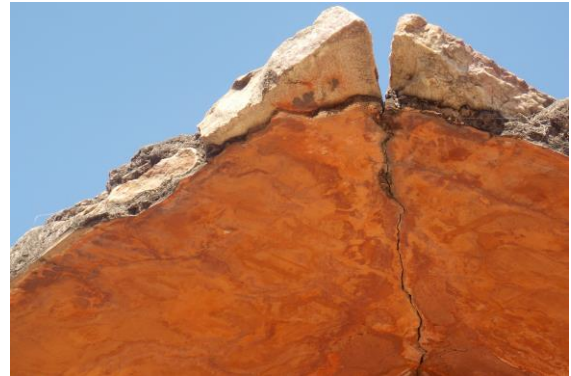
Photo 126

Damaged Portion on Sunshade of Main Gate, Part A of House No. 2144, First Floor

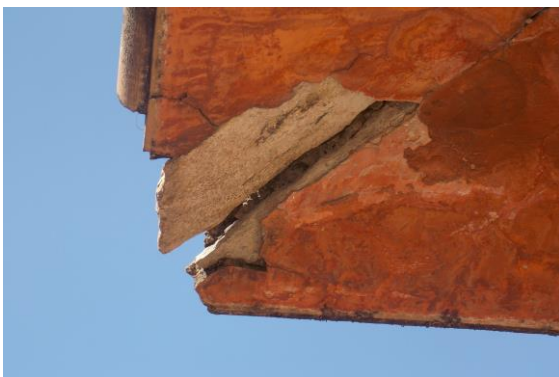
Photo 127

Damaged Portion on Sunshade of Main Gate, Part A of House No. 2144, First Floor

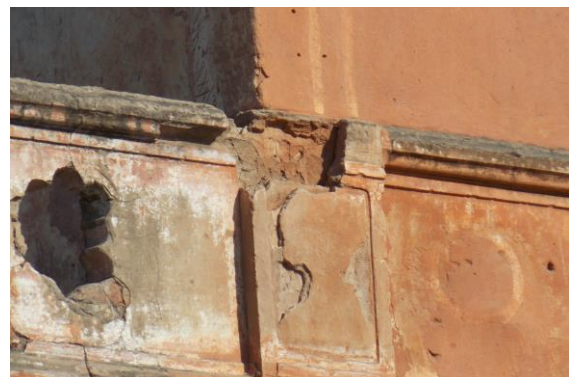
Photo 128

Damaged Portion on Wall No. 3 of External Parapit Wall of House No. 2144, First Floor

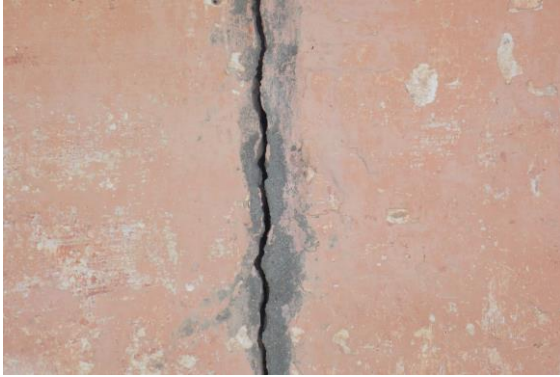
Photo 129  
Damaged Portion on External Wall of Room No. 1 of House No. 2144, Second Floor

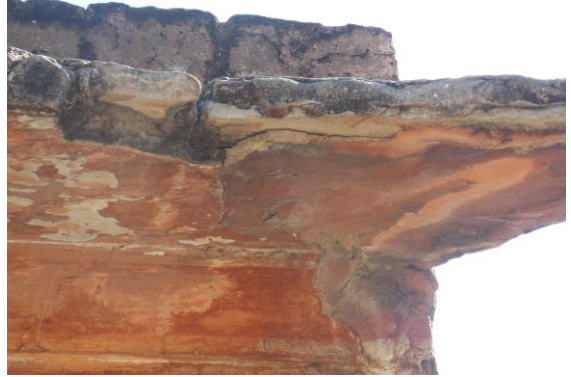
Photo 130  
Damaged Portion on External Wall & Sunshade of Room No. 1 of House No. 2144, Second Floor

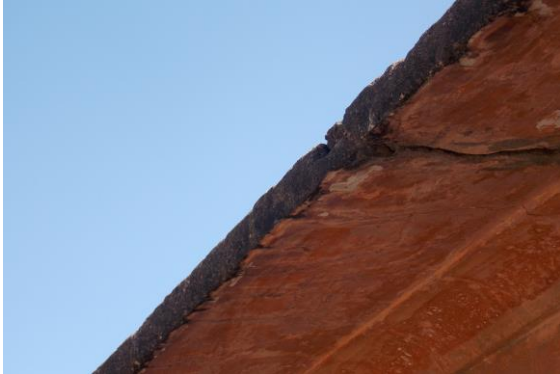
Photo 131  
Damaged Portion on External Wall & Sunshade of Room No. 1 of House No. 2144, Second Floor

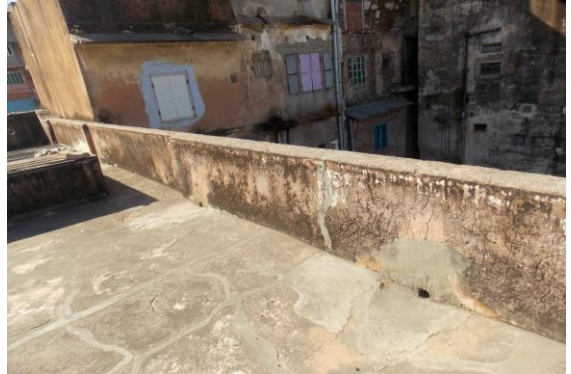
Photo 132  
Peeling of Plaster on Wall No. 2 of Room No. 1 of House No. 2144, Second Floor

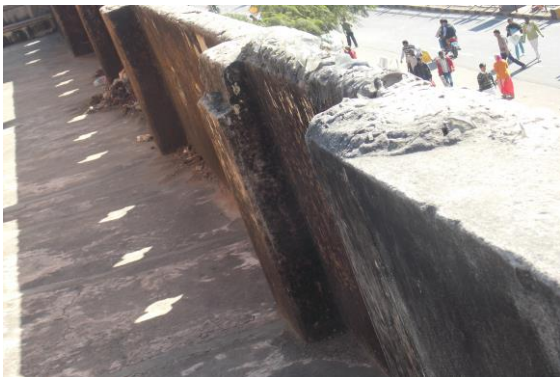
Photo 133  
Dampness/Seepage on Wall No. 4 of Room No. 1 of House No. 2144, Second Floor

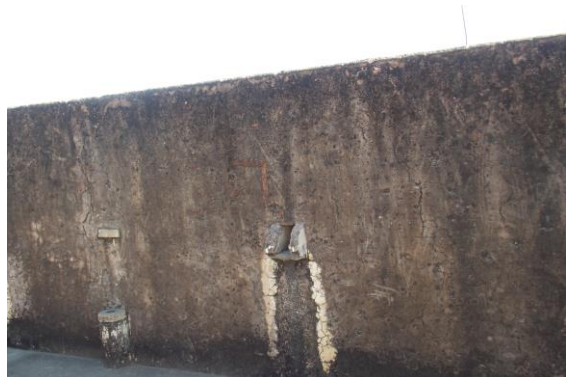
Photo 134  
Plaster Crack on Wall No. 1 of Room No. 1 of House No. 2144, Second Floor

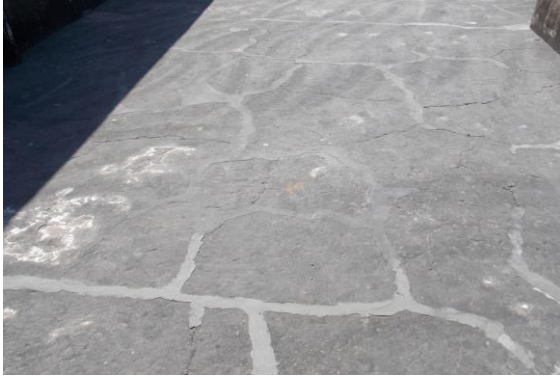
Photo 135

Peeling of Plaster on Floor of Room No. 1 of House No. 2144, Second Floor

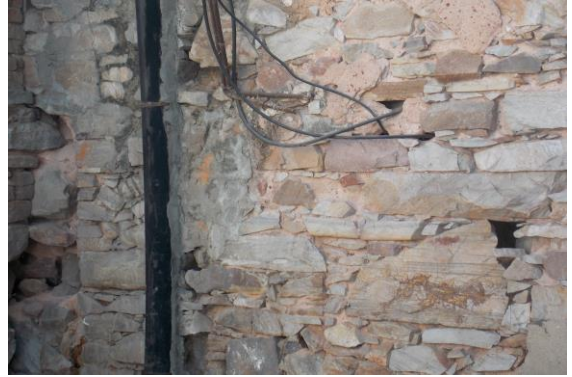
Photo 136

Damaged Portion on Backside Wall of Part B of House No. 2144, Ground Floor

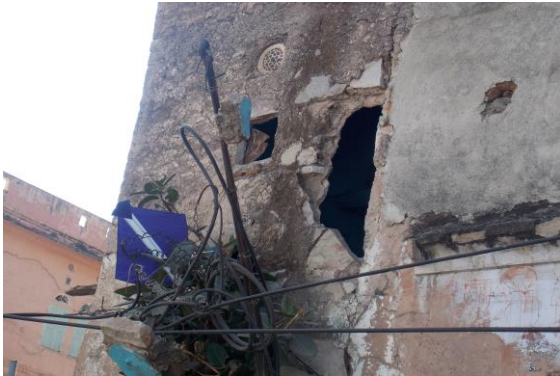
Photo 137

Damaged Portion on Backside Wall of Part B of House No. 2144, Ground Floor

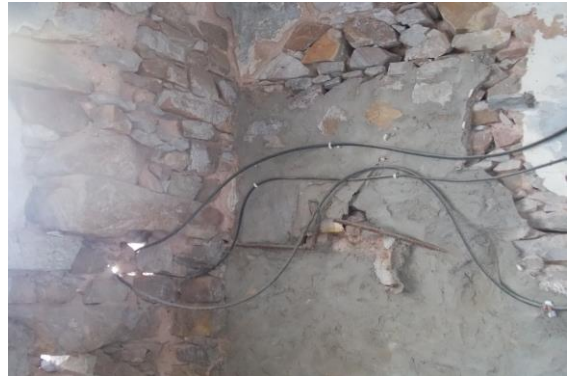
Photo 138

Damaged Portion on Wall No. 1 & 3 of Passage 1, Part B of House No. 2144, Ground Floor

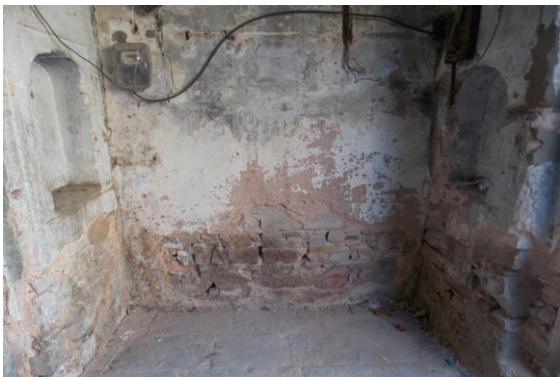
Photo 139

Damaged Portion on Wall No. 2, 3 & 4 of Passage 1, Part B of House No. 2144, Ground Floor

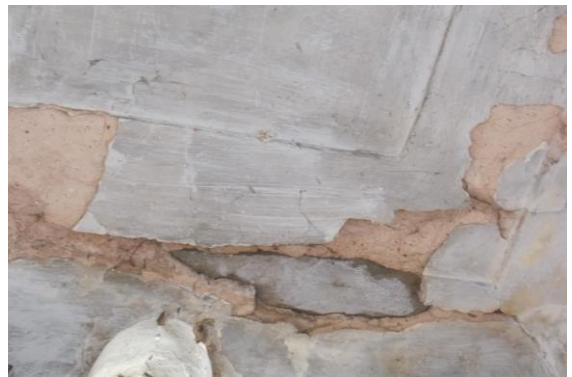
Photo 140

Damaged Portion on Roof of Passage 1, Part B of House No. 2144, Ground Floor

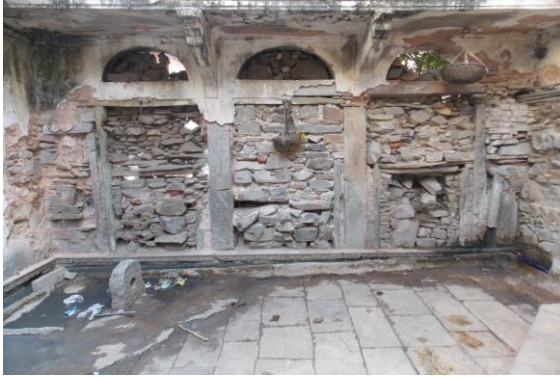
Photo 141

Damaged Portion on Wall No. 1, 3 & 4 of Passage 1, Part B of House No. 2144, Ground Floor

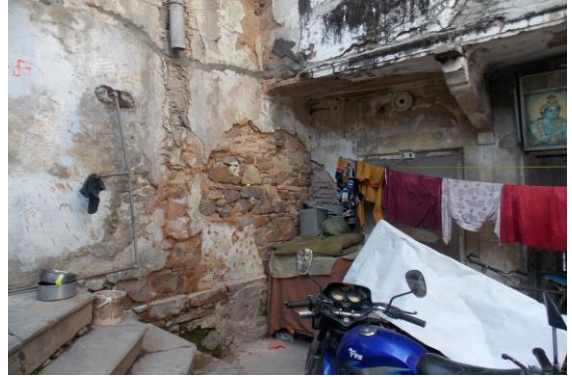
Photo 142

Damaged Portion on Wall No. 4 & 2 of Passage 1, Part B of House No. 2144, Ground Floor

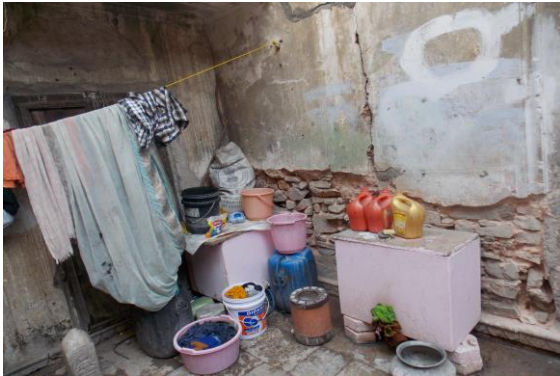
Photo 143

Damaged Portion on Wall No. 3 of Passage 1, Part B of House No. 2144, Ground Floor

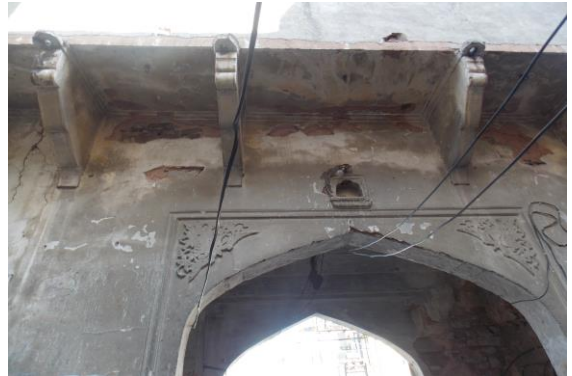
Photo 144

Damaged Portion on Wall No. 3 & Sunshade of Passage 1, Part B of House No. 2144, Ground Floor

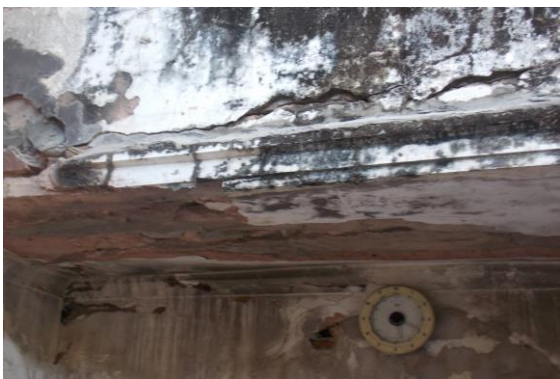
Photo 145

Peeling of Plaster on Wall No. 2 & Sunshade of Passage 1, Part B of House No. 2144, Ground Floor

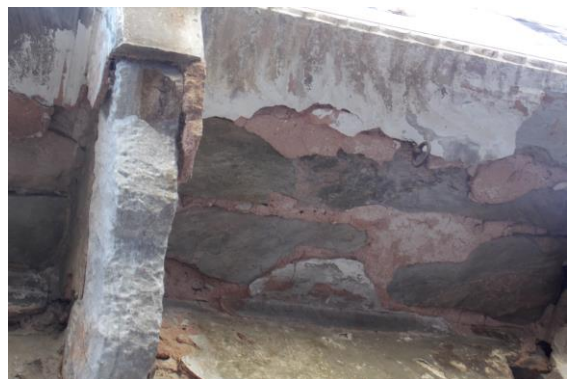
Photo 146

Peeling of Plaster on Wall No. 4 & Sunshade of Passage 1, Part B of House No. 2144, Ground Floor

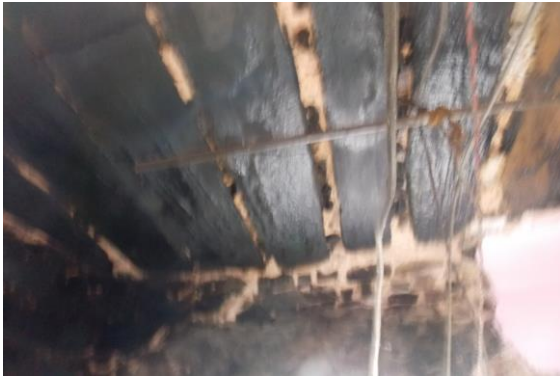
Photo 147

Peeling of Plaster on Wall No. 3 & Roof of Passage 2, Part B of House No. 2144, Ground Floor

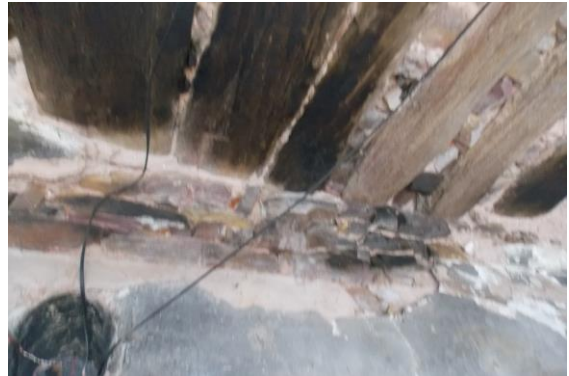
Photo 148

Peeling of Plaster on Wall No. 3 & Roof of Passage 2, Part B of House No. 2144, Ground Floor

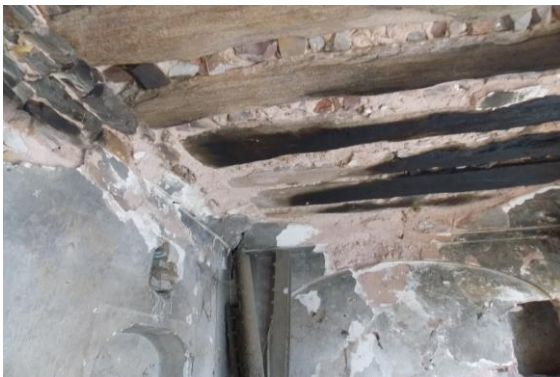
Photo 149

Damaged Portion on Wall No. 1, 2, 3, 4 & Roof of Varanda, Part B of House No. 2144, Ground Floor

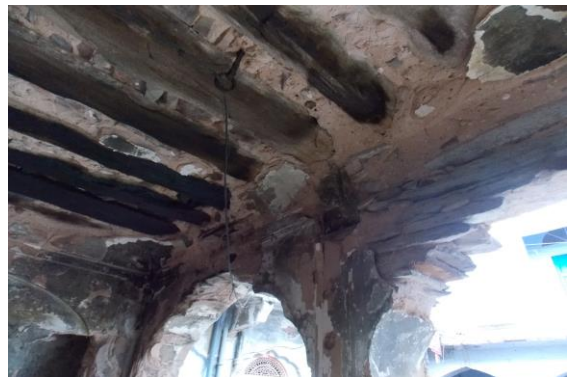
Photo 150

Damaged Portion on Wall No. 1, 2, 3, 4 & Roof of Varanda, Part B of House No. 2144, Ground Floor

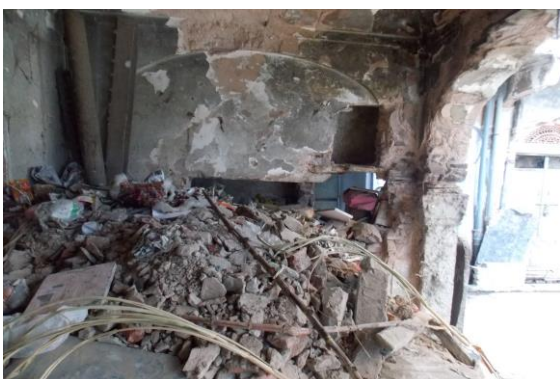
Photo 151

Damaged Portion on Wall No. 1, 2, 3, 4 & Roof of Varanda, Part B of House No. 2144, Ground Floor

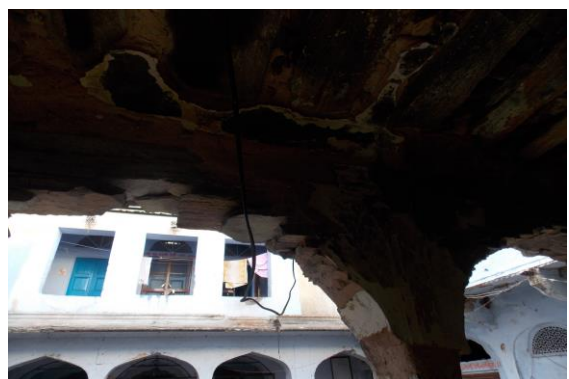
Photo 152

Damaged Portion on Wall No. 1, 2, 3, 4 & Roof of Varanda, Part B of House No. 2144, Ground Floor

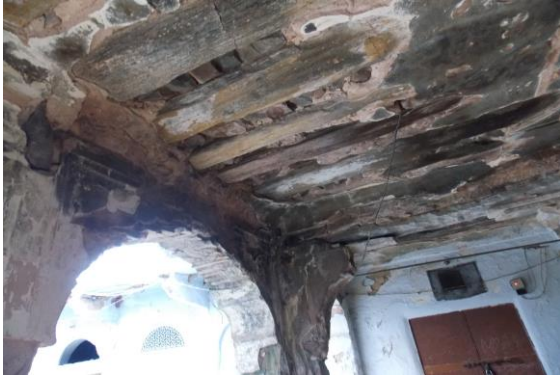
Photo 153

Damaged Portion on Wall No. 1, 2, 3, 4 & Roof of Varanda, Part B of House No. 2144, Ground Floor

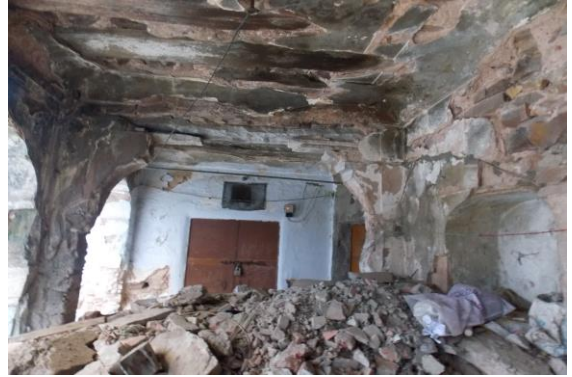
Photo 154

Damaged Portion on Wall No. 1, 2, 3, 4 & Roof of Varanda, Part B of House No. 2144, Ground Floor

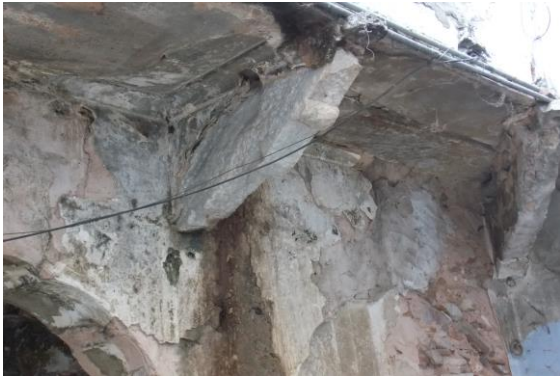
Photo 155

Peeling of Plaster on Wall No. 3 & Sunshade of Open Sky , Part B of House No. 2144, Ground Floor

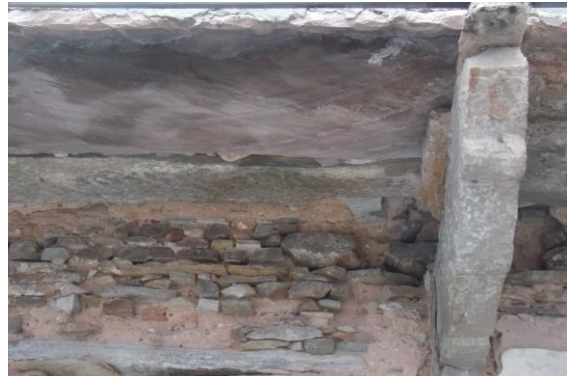
Photo 156

Peeling of Plaster on Wall No. 3 & Sunshade of Open Sky , Part B of House No. 2144, Ground Floor

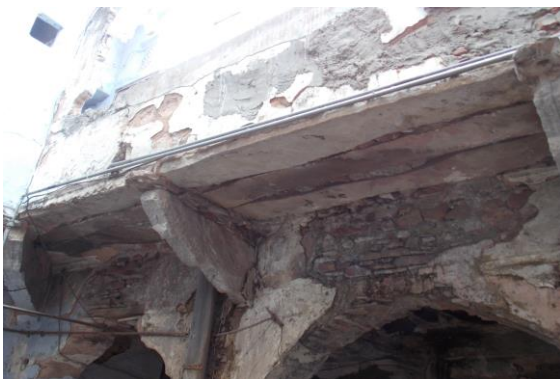
Photo 157

Peeling of Plaster on Wall No. 3 & Sunshade of Open Sky , Part B of House No. 2144, Ground Floor

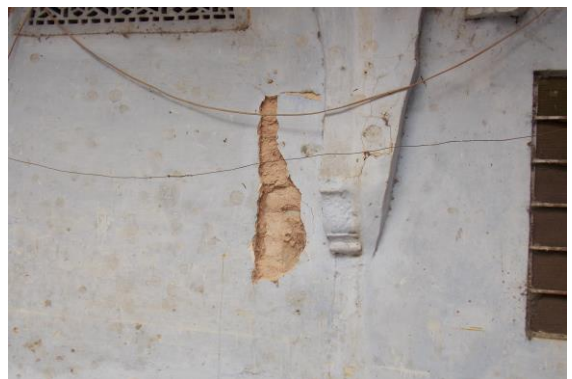
Photo 158

Peeling of Plaster on Wall No. 2 & Sunshade of Open Sky , Part B of House No. 2144, Ground Floor

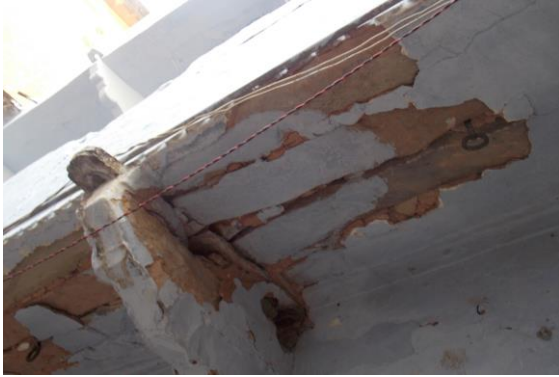
Photo 159

Peeling of Plaster on Wall No. 2 & Sunshade of Open Sky , Part B of House No. 2144, Ground Floor

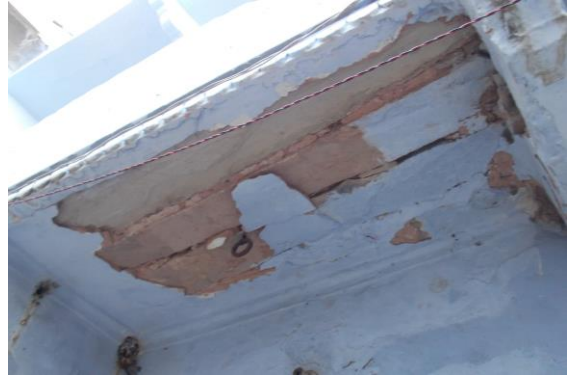
Photo 160

Peeling of Plaster on Wall No. 2 & Sunshade of Open Sky , Part B of House No. 2144, Ground Floor

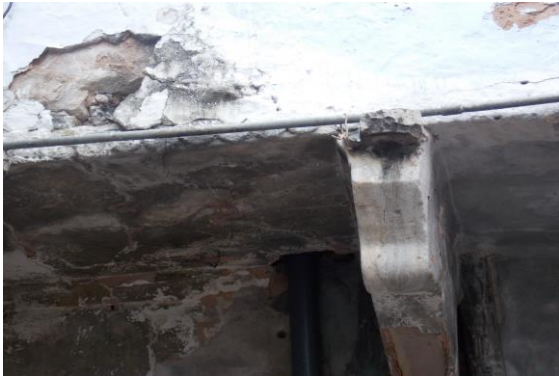
Photo 161

Peeling of Plaster on Wall No. 1 & Sunshade of Open Sky , Part B of House No. 2144, Ground Floor

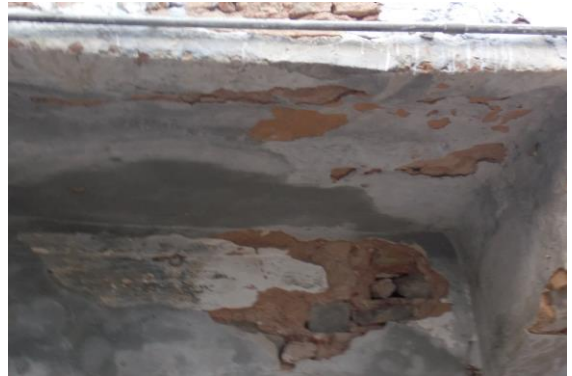
Photo 162

Peeling of Plaster on Wall No. 1 & Sunshade of Open Sky , Part B of House No. 2144, Ground Floor

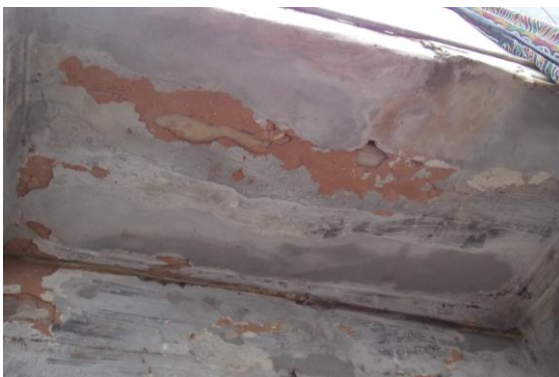
Photo 163

Peeling of Plaster on Wall No. 1 & Sunshade of Open Sky , Part B of House No. 2144, Ground Floor

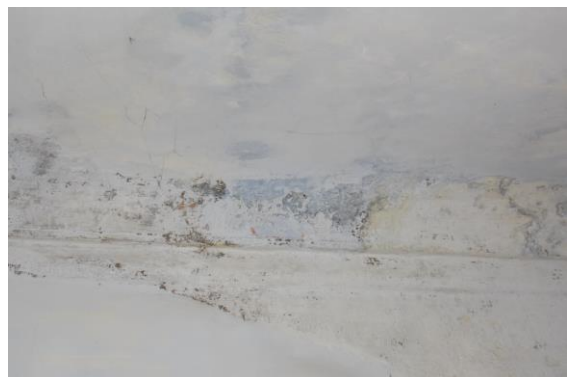
Photo 164

Dampness/Seepage on Roof of Varanda 3, Part B of House No. 2144, Ground Floor

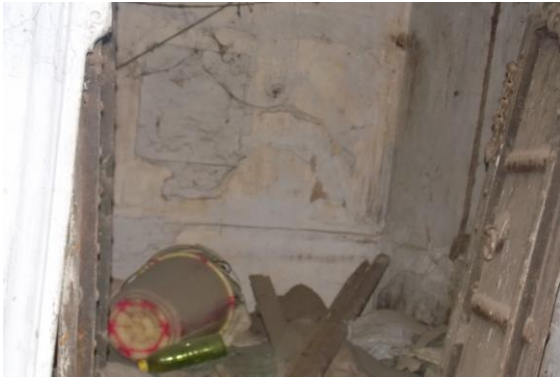
Photo 165

Peeling of Plaster on Wall No. 4 of Room No. 6 of Part B, House No. 2144, Ground Floor

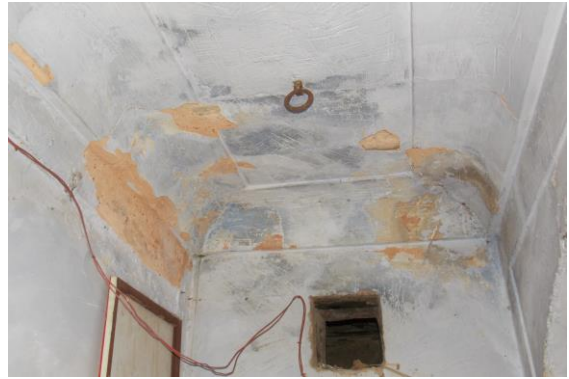
Photo 166

Peeling of Plaster on Wall No. 4 & Roof of Varanda 2, Part B of House No. 2144, Ground Floor

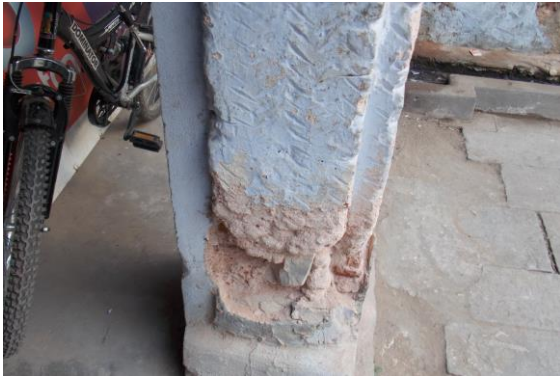
Photo 167

Dampness/Seepage on Collumn 4 of Part B of House No. 2144, Ground Floor

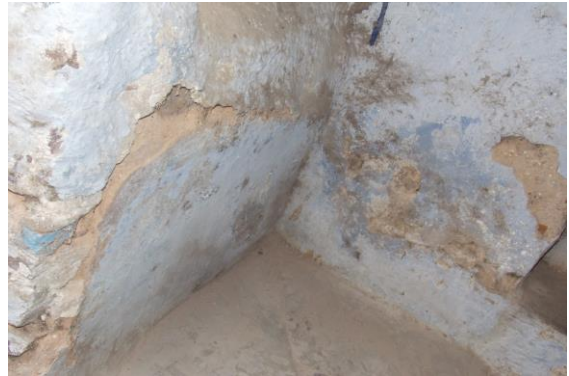
Photo 168

Peeling of Plaster on All Wall of Stair First to Second Floor of House No. 2144

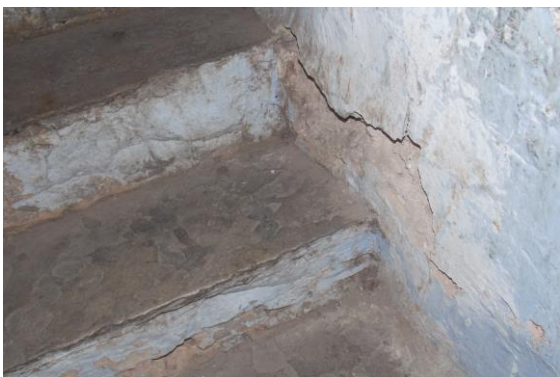
Photo 169

Peeling of Plaster on All Wall of Stair First to Second Floor of House No. 2144

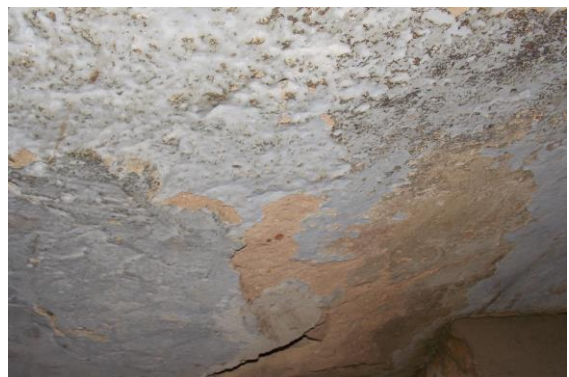
Photo 170

Peeling of Plaster on All Wall of Stair First to Second Floor of House No. 2144

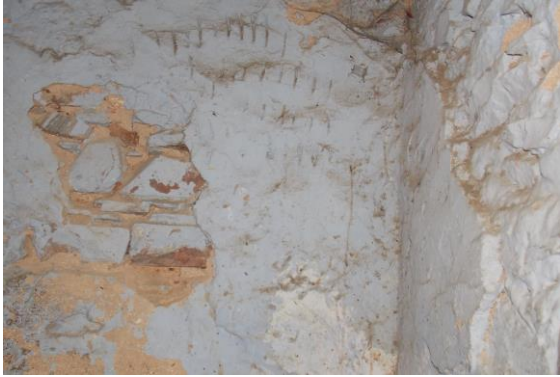
Photo 171

Peeling of Plaster on All Wall of Stair First to Second Floor of House No. 2144

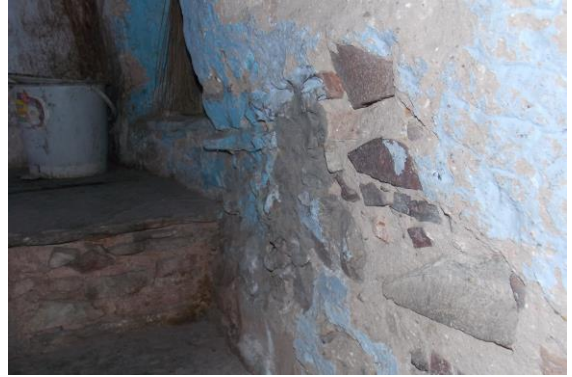
Photo 172

Peeling of Plaster on All Wall of Stair First to Second Floor of House No. 2144

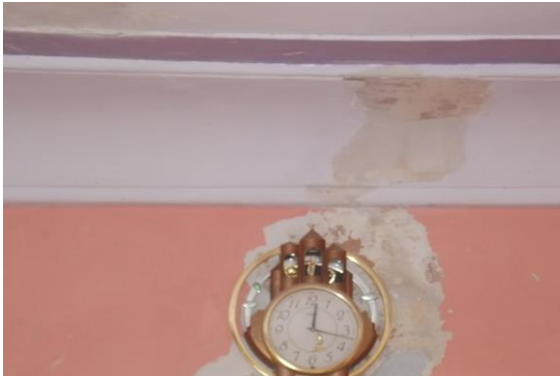
Photo 173

Dampness/Seepage on Wall No. 2 & Roof of Room No. 2 of House No. 2144, First Floor

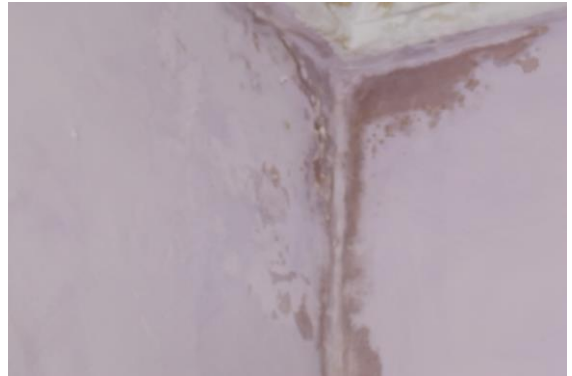
Photo 174

Dampness/Seepage on Wall No. 1 & 3 of Room No. 3 of House No. 2144, First Floor

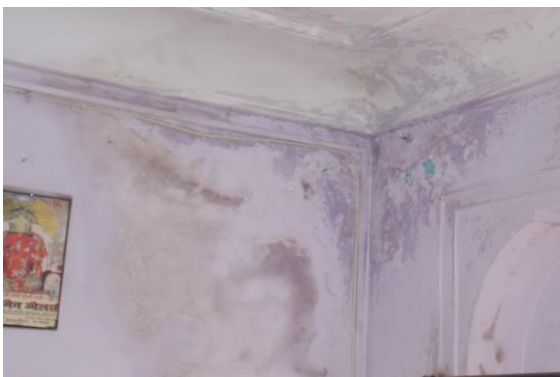
Photo 175

Dampness/Seepage on Wall No. 1, 4 & Roof of Room No. 4 of House No. 2144, First Floor

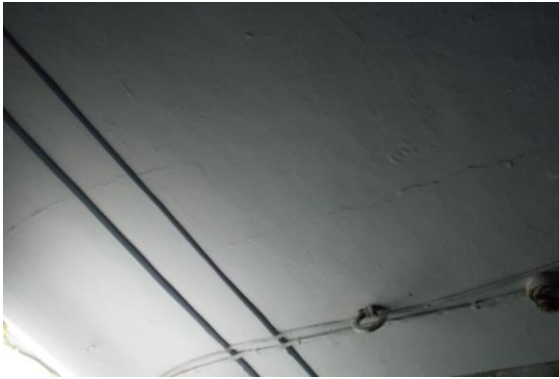
Photo 177

Plaster Crack on Roof of Room No. 8 of House No. 2144, First Floor

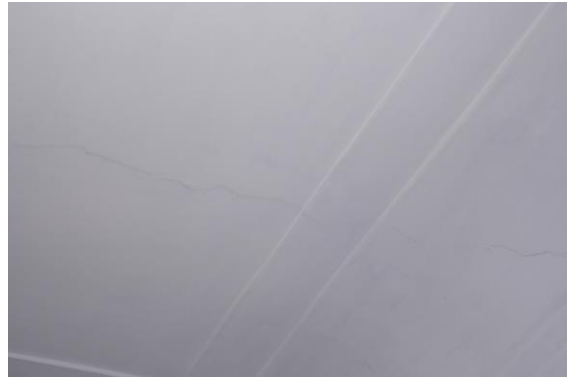
Photo 178

Plaster Crack on Roof of Room No. 8 of House No. 2144, First Floor

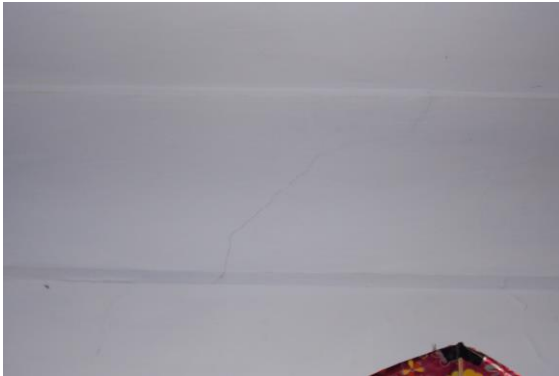
Photo 179

Plaster Crack on Roof of Room No. 9 of House No. 2144, First Floor

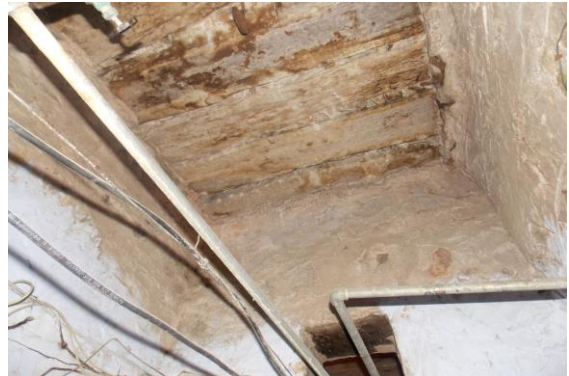
Photo 180

Peeling of Plaster on Wall No. 2 & Roof of Balcony, Part B of House No. 2144, First Floor

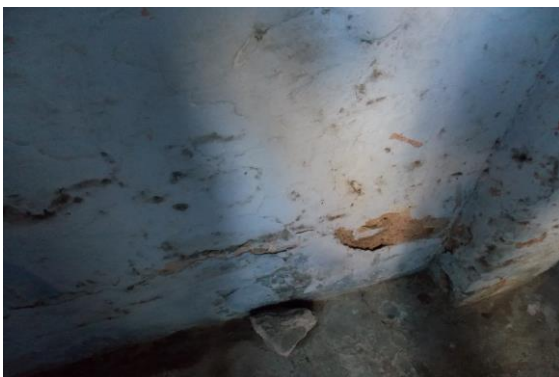
Photo 181

Peeling of Plaster on Wall No. 2 & Roof of Balcony, Part B of House No. 2144, First Floor

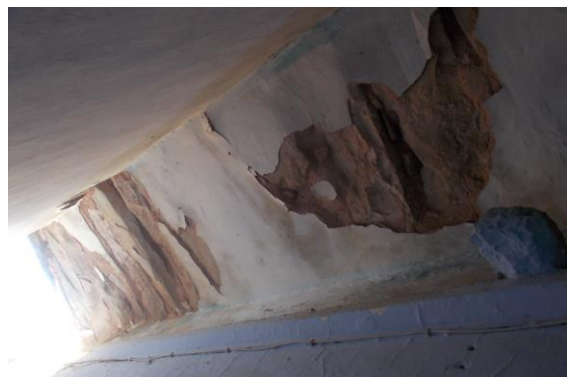
Photo 182

Peeling of Plaster on Roof of Balcony, Part B of House No. 2144, First Floor

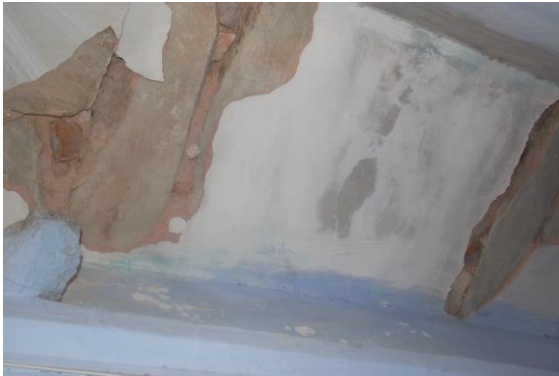
Photo 183

Peeling of Plaster on Roof of Balcony, Part B of House No. 2144, First Floor

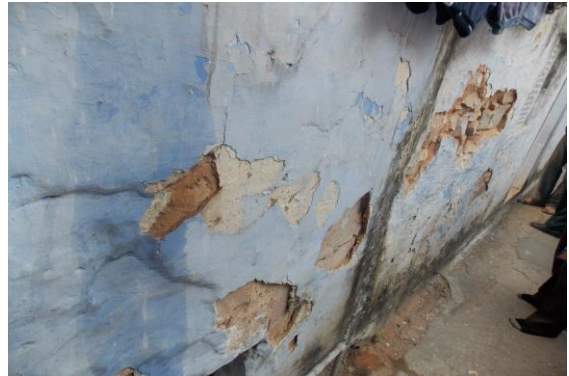
Photo 184

Peeling of Plaster on Wall No. 3 of Balcony, Part B of House No. 2144, First Floor

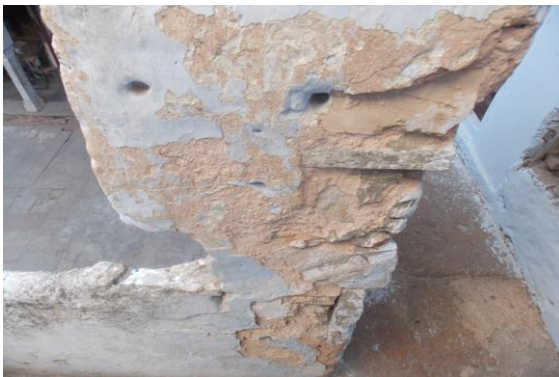
Photo 185

Peeling of Plaster on Wall No. 1 of Open Sky, Part B of House No. 2144, First Floor

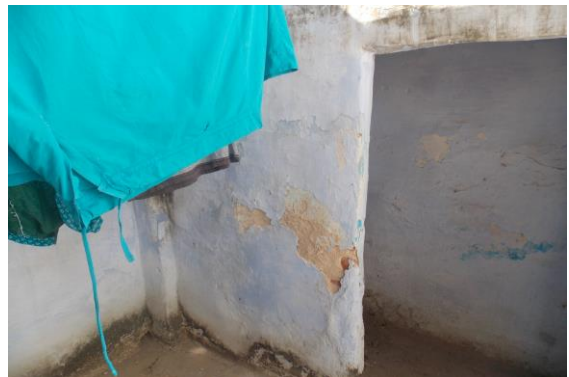
Photo 186

Peeling of Plaster on Stair First to Second Floor of House No. 2144, First Floor

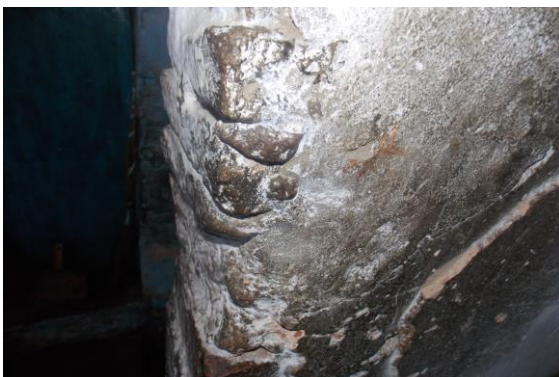
Photo 187

Damaged Portion on All Wall & Roof of Stair First to Second Floor of House No. 2144, First Floor

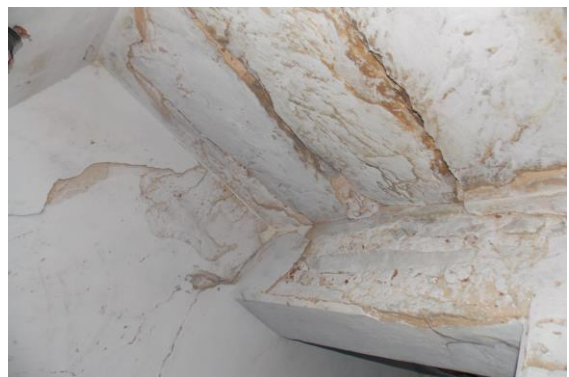
Photo 188

Damaged Portion on All Wall & Roof of Stair First to Second Floor of House No. 2144, First Floor

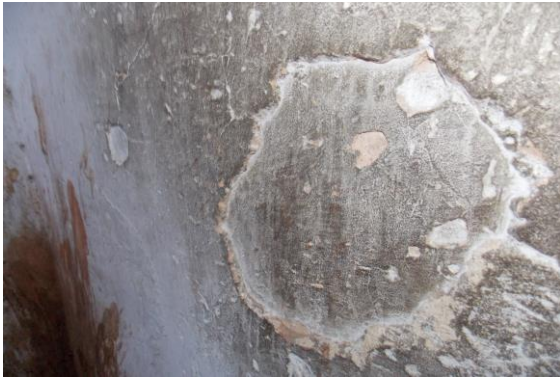
Photo 189

Damaged Portion on All Wall & Roof of Stair First to Second Floor of House No. 2144, First Floor

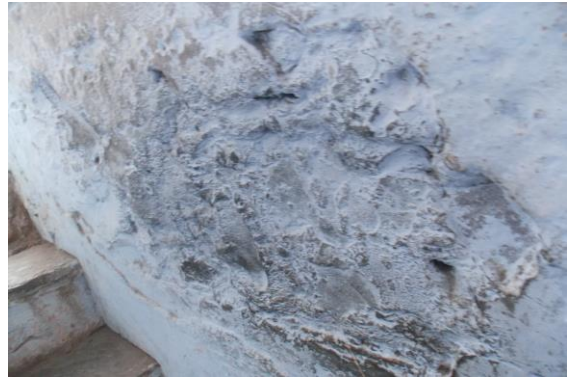
Photo 190

Damaged Portion on All Wall & Roof of Stair First to Second Floor of House No. 2144, First Floor

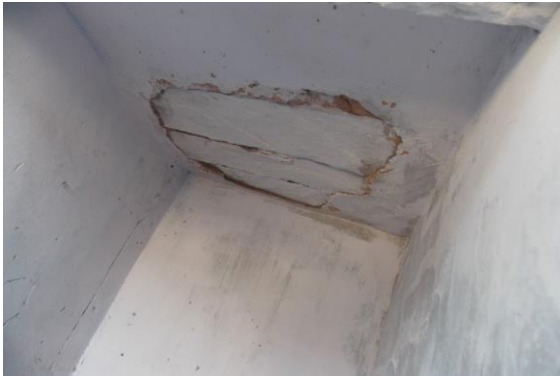
Photo 191

Damaged Portion on All Wall & Roof of Stair First to Second Floor of House No. 2144, First Floor

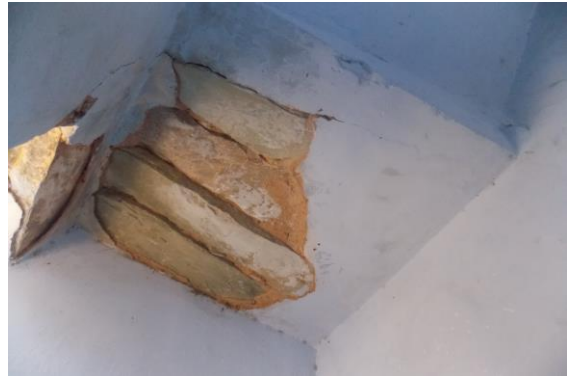
Photo 192

Damaged Portion on All Wall & Roof of Stair First to Second Floor of House No. 2144, First Floor

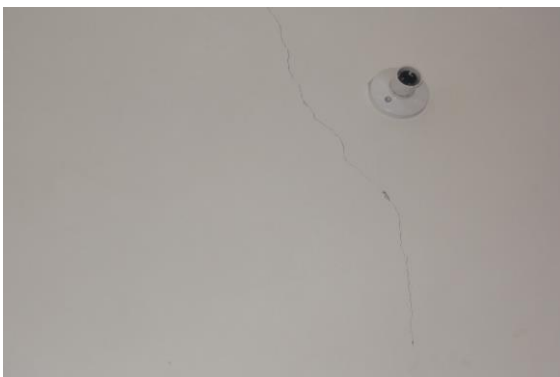
Photo 193

Plaster Crack on Wall No. 3 of Hall No. 1 of Part B, House No. 2144, Second Floor

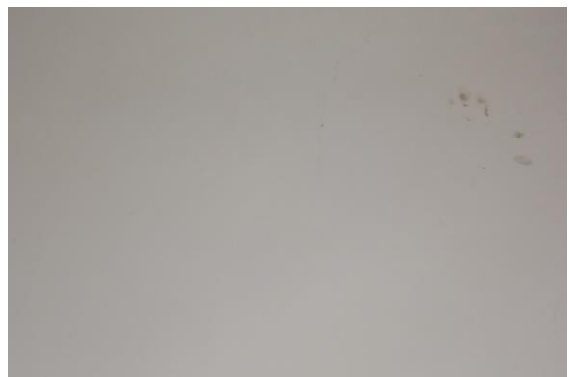
Photo 194

Plaster Crack on Wall No. 2 of Hall No. 1 of Part B, House No. 2144, Second Floor
