### Pre Building Condition Survey Report

Name and Address of Structure :	Badi Chopar to Ramp Area (UP Line)
---------------------------------	------------------------------------

Name of the Project	<b>Contract JMRC-UG1B</b> “Design and Construction of Tunnel between Chandpole and Badi Chouper and reverse line by Shield TBM, Underground Metro Stations at Choti Chouper and Badi Chouper by Cut and Cover Methods on East West Corridor of Jaipur Metro Rail Corporation Limited .”	
Owner :

Pre Building Condition Survey Report Badi Chopar to Ramp Area (UP Line)

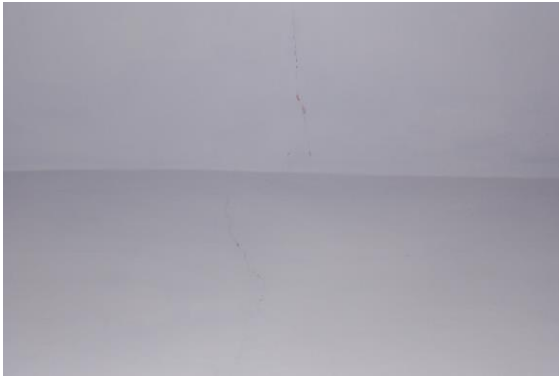
Photo 195

Plaster Crack on Wall No. 4 & Roof of Toilet No. 1 of Part B, House No. 2144, Second Floor

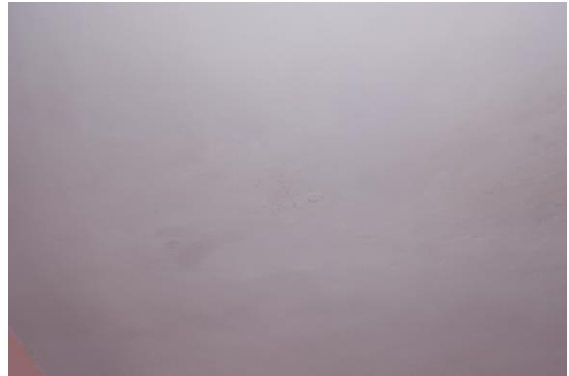
Photo 196

Dampness/Seepage on Roof of Room No. 4 of Part B, House No. 2144, Second Floor

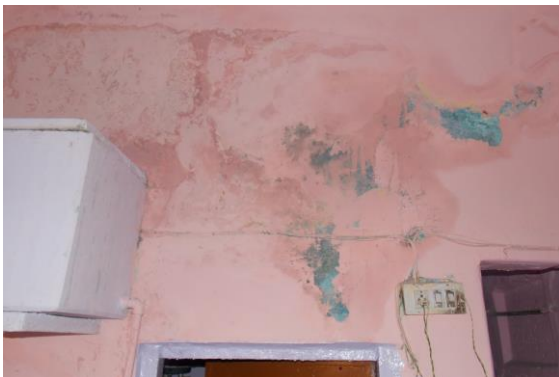
Photo 197

Dampness/Seepage on Wall No. 2 of Room No. 4 of Part B, House No. 2144, Second Floor

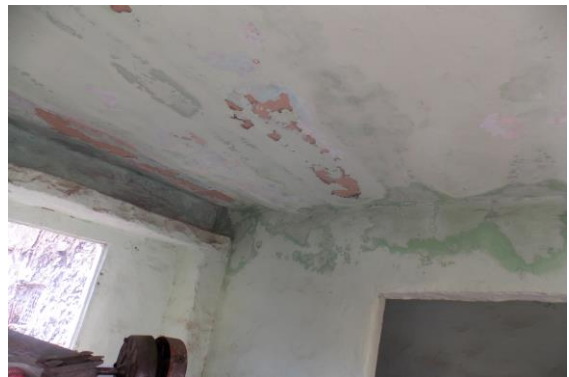
Photo 198

Dampness/Seepage on Wall No. 1, 2, 4 & Roof of Store 2, Part B of House No. 2144, Second Floor

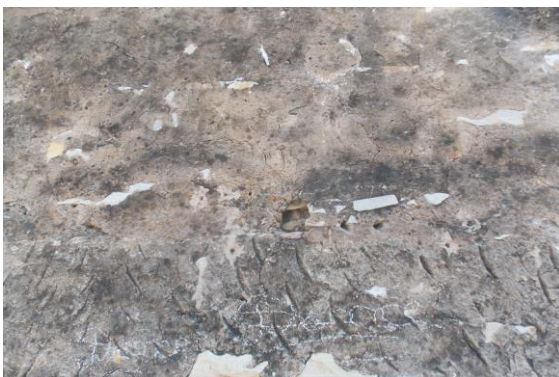
Photo 199

Peeling of Plaster on Wall No. 3 of Open Sky, Part B of House No. 2144, Second Floor

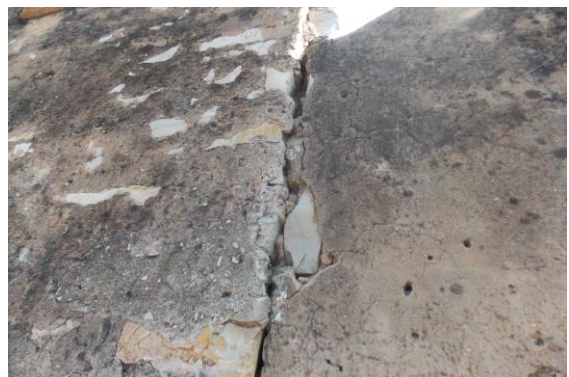
Photo 200

Damaged Portion on Wall No. 3 of Open Sky, Part B of House No. 2144, Second Floor

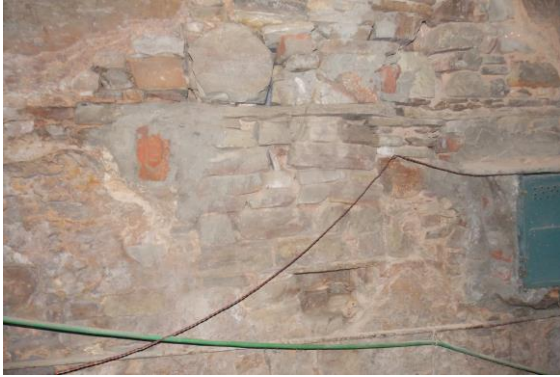
Photo 201

Damaged Portion on All Wall & Roof of Passage 1, Part C of House No. 2144, Ground Floor

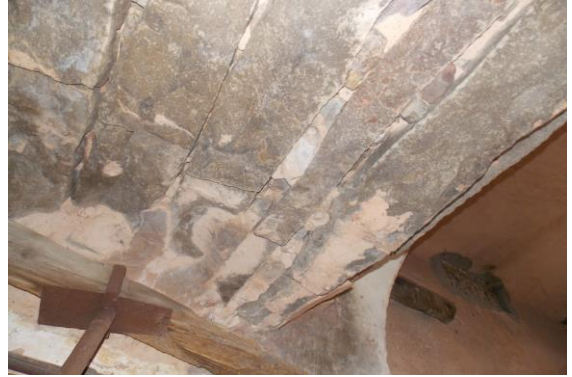
Photo 202

Peeling of Plaster on Wall No. 1 of Open Sky 1, Part C of House No. 2144, Ground Floor

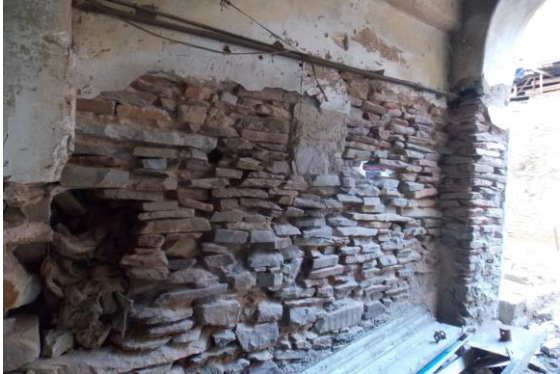
Photo 203

Peeling of Plaster on Wall No. 2 of Open Sky 1, Part C of House No. 2144, Ground Floor

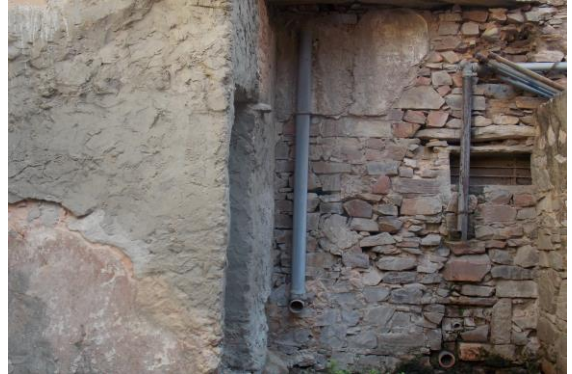
Photo 204

Peeling of Plaster on Wall No. 1 of Open Sky 1, Part C of House No. 2144, Ground Floor

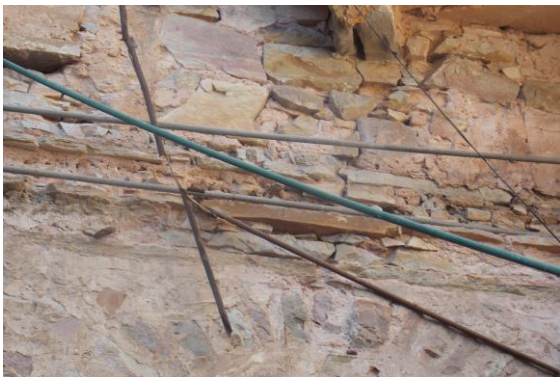
Photo 205

Peeling of Plaster on Wall No. 2 of Open Sky 1, Part C of House No. 2144, Ground Floor

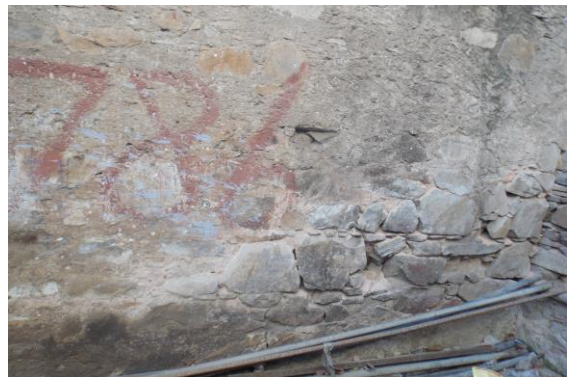
Photo 206

Peeling of Plaster on Wall No. 4 of Open Sky 1, Part C of House No. 2144, Ground Floor

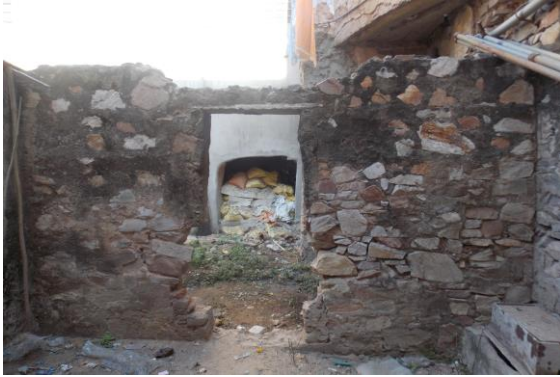
Photo 207

Peeling of Plaster on Wall No. 1, 2, 3 & 4 of Open Sky 2 , Part C of House No. 2144, Ground Floor

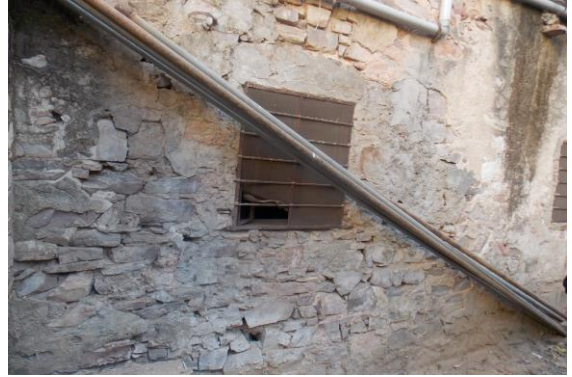
Photo 208

Peeling of Plaster on Wall No. 1, 2, 3 & 4 of Open Sky 2 , Part C of House No. 2144, Ground Floor

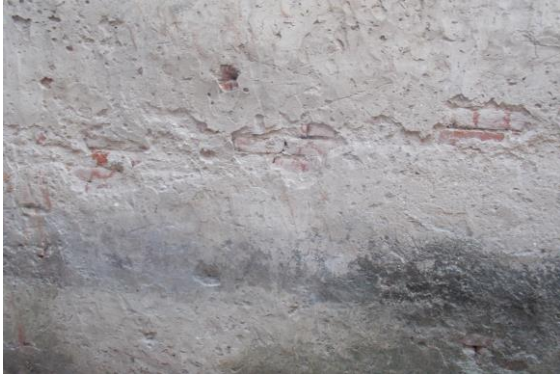
Photo 209

Peeling of Plaster on Wall No. 1, 2, 3 & 4 of Open Sky 2 , Part C of House No. 2144, Ground Floor

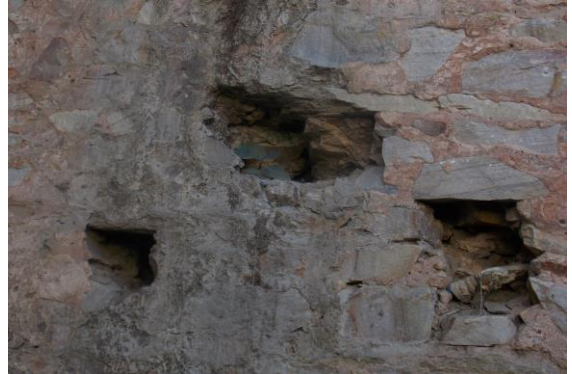
Photo 210

Peeling of Plaster on Wall No. 1, 2, 3 & 4 of Open Sky 2 , Part C of House No. 2144, Ground Floor

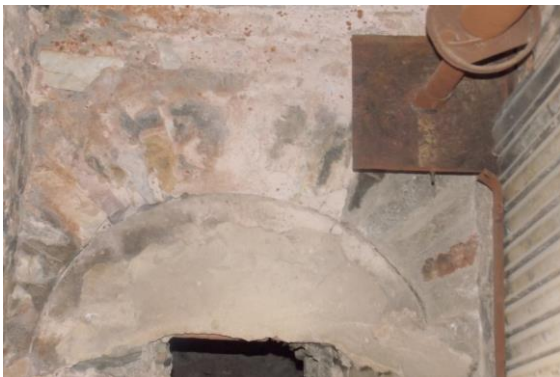
Photo 211

Peeling of Plaster on All Wall & Roof of Passage 2, Part c of House No. 2144, Ground Floor

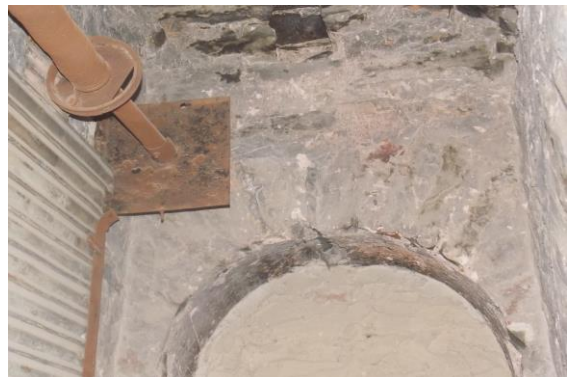
Photo 212

Peeling of Plaster on All Wall & Roof of Passage 2, Part c of House No. 2144, Ground Floor

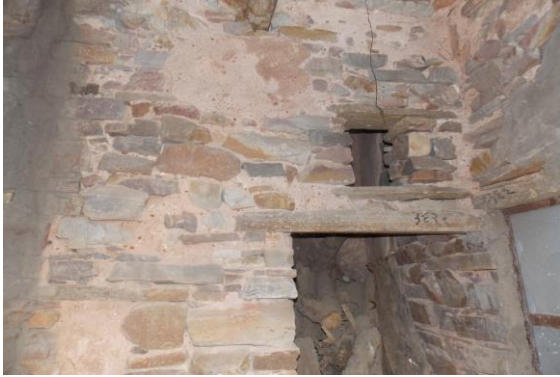
Photo 213

Peeling of Plaster on All Wall & Roof of Varanda, Part c of House No. 2144, Ground Floor

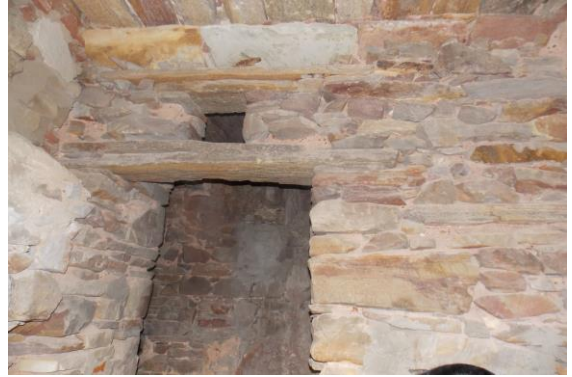
Photo 214

Peeling of Plaster on Wall No. 4 of Toilet No. 1 of Part C, House No. 2144, Ground Floor

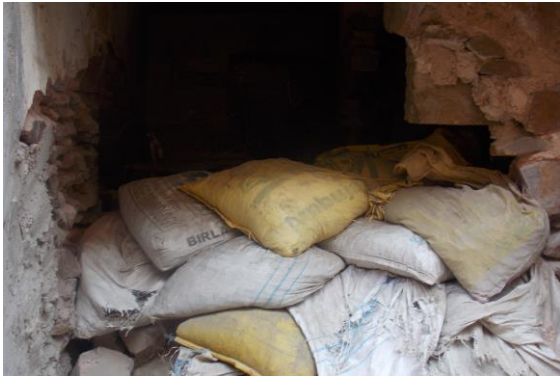
Photo 215

Peeling of Plaster on Wall No. 2 of Room No. 1 of Part C, House No. 2144, Ground Floor

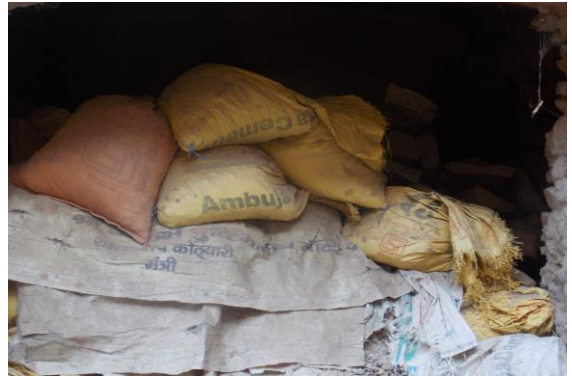
Photo 216

Peeling of Plaster on Wall No. 4 of Room No. 2 of Part C, House No. 2144, Ground Floor

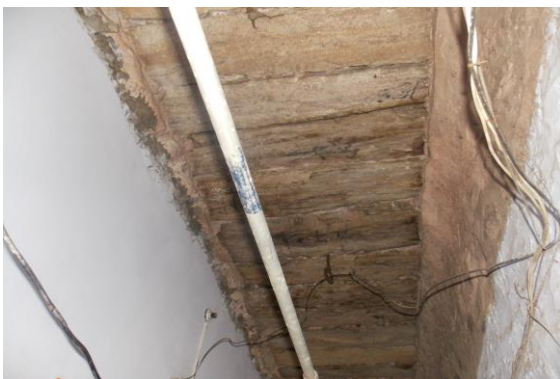
Photo 217

Peeling of Plaster on Roof of Passage 1, Part C of House No. 2144, First Floor

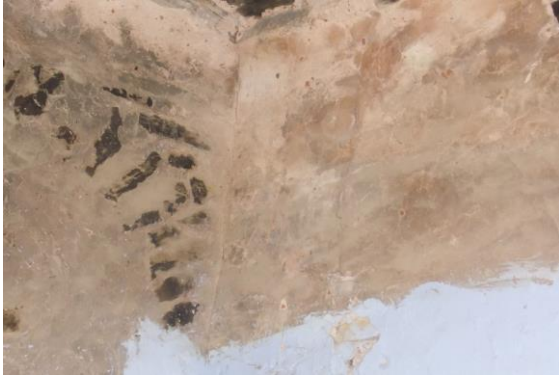
Photo 219

Peeling of Plaster on All Wall & Roof of Passage 2, Part C of House No. 2144, First Floor

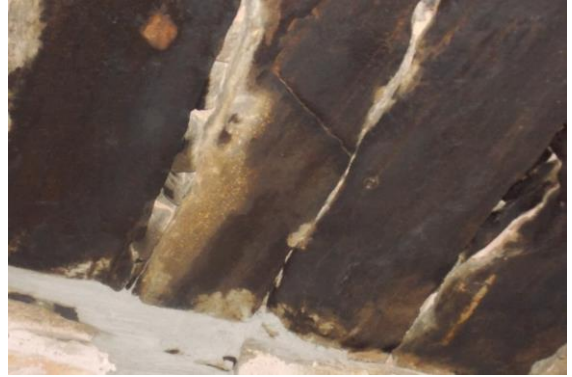
Photo 220

Peeling of Plaster on All Wall & Roof of Passage 2, Part C of House No. 2144, First Floor

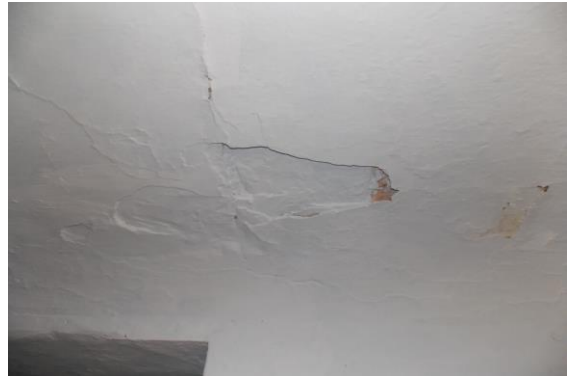
Photo 222

Peeling of Plaster on Roof of Room No. 1 of Part C, House No. 2144, First Floor

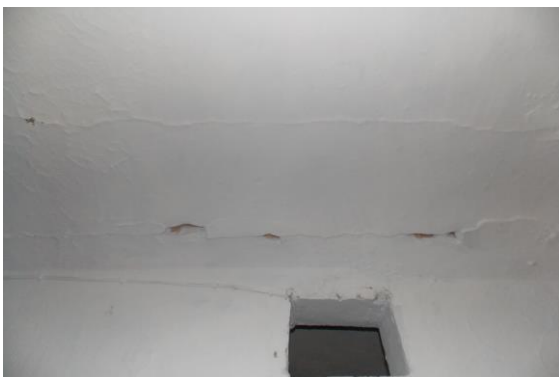
Photo 223

Peeling of Plaster on Wall No. 2 of Room No. 1 of Part C, House No. 2144, First Floor

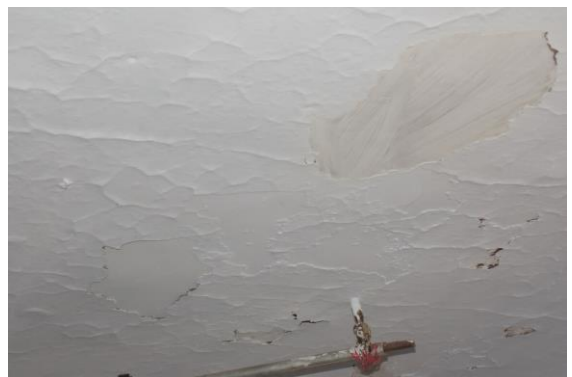
Photo 224

Peeling of Plaster on Wall No. 2 of Room No. 1 of Part C, House No. 2144, First Floor

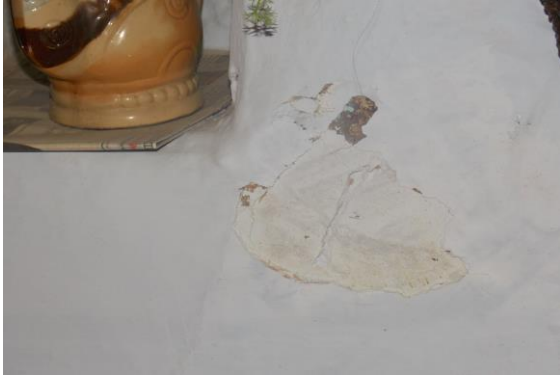
Photo 225

Peeling of Plaster on Wall No. 2 of Room No. 1 of Part C, House No. 2144, First Floor

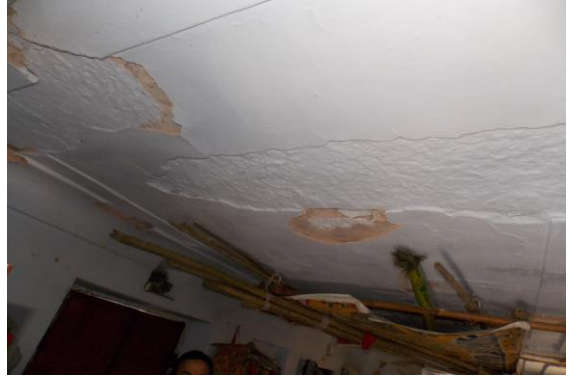
Photo 226

Peeling of Plaster on Roof of Room No. 1 of Part C, House No. 2144, Second Floor

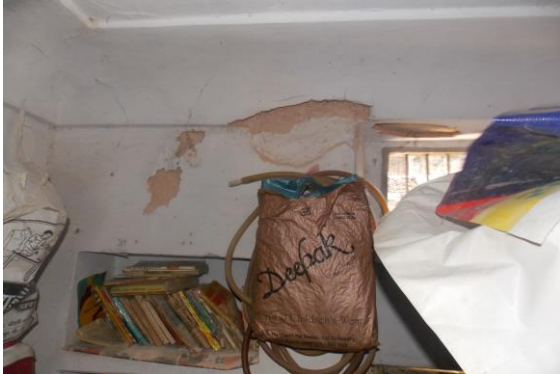
Photo 227

Peeling of Plaster on Wall No. 4 of Room No. 1 of Part C, House No. 2144, Second Floor

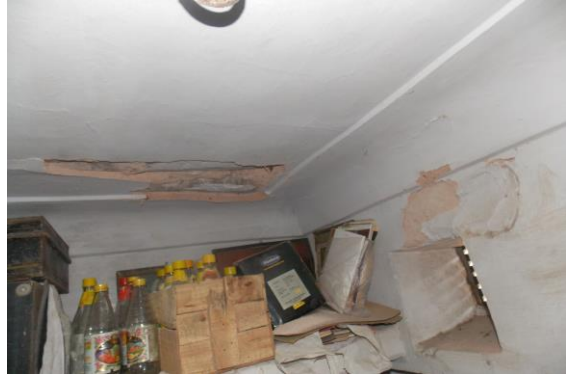
Photo 228

Peeling of Plaster on Wall No. 2 & Roof of Room No. 2 of Part C, House No. 2144, Second Floor

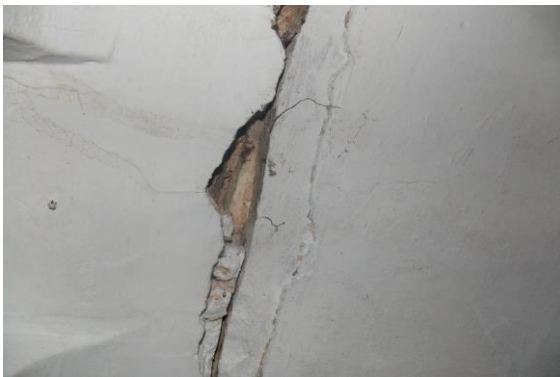
Photo 229

Peeling of Plaster on Roof of Room No. 2 of Part C, House No. 2144, Second Floor

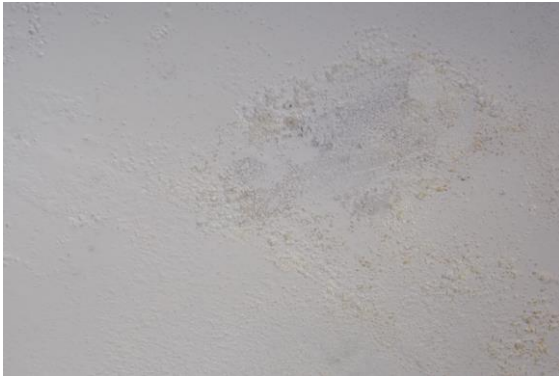
Photo 231

Dampness/Seepage on Roof of Bathroom of Part C, House No. 2144, Second Floor

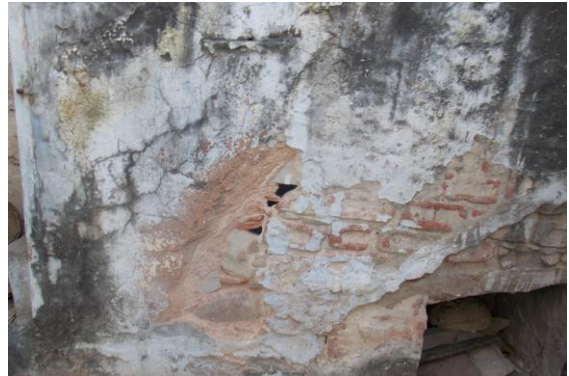
Photo 232

Peeling of Plaster on External Wall of Bathroom No. of Part C, House No. 2144, Second Floor

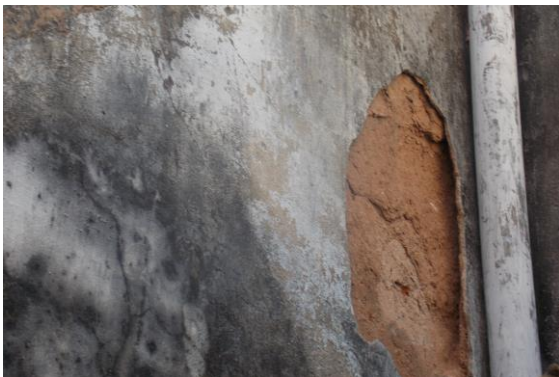
Photo 233

Peeling of Plaster on External Wall of Bathroom No. of Part C, House No. 2144, Second Floor

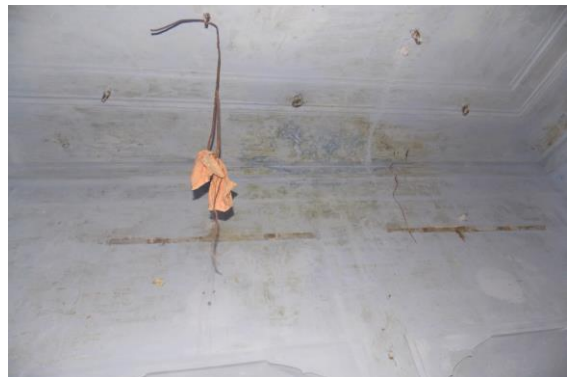
Photo 234

Dampness/Seepage on Roof of Hall No. 4 of House No. 2144, Second Floor, Passage, Part C

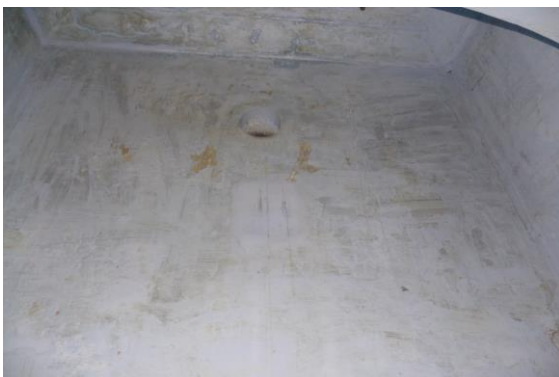
Photo 235

Dampness/Seepage on Wall No. 2 of Hall No. 4 of House No. 2144, Second Floor, Passage, Part C

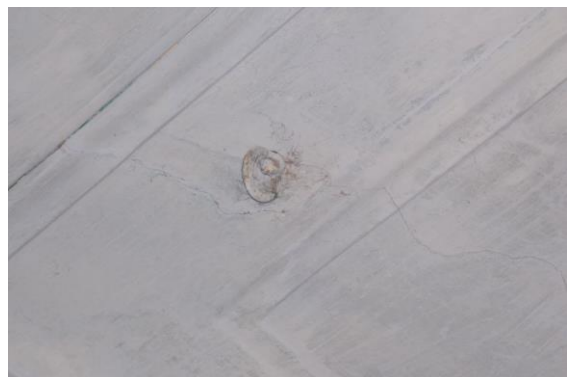
Photo 236

Plaster Crack on Roof of Hall No. 4 of House No. 2144, Second Floor, Passage, Part C

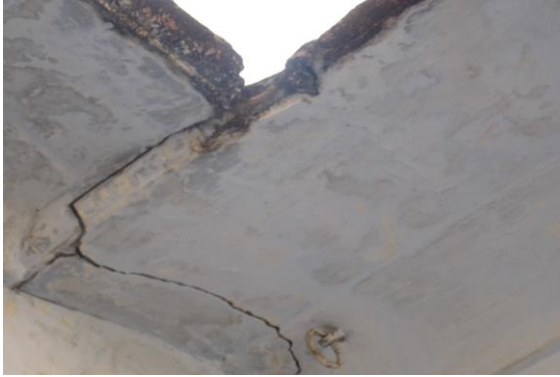
Photo 237

Damaged Portion on Sunshade of of House No. 2144, First Floor, Open Sky, Part B, Part 2

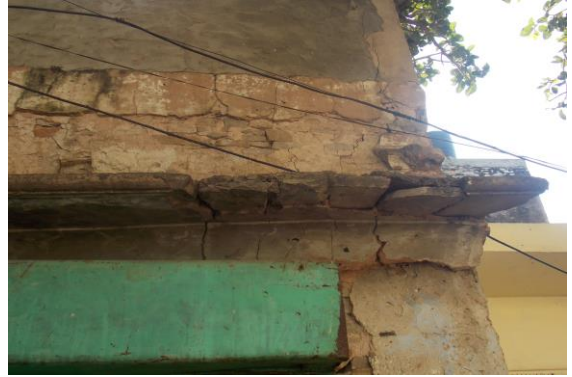
Photo 238

Damaged Portion on Sunshade of Back side, Part C of House No. 2144, Ground Floor

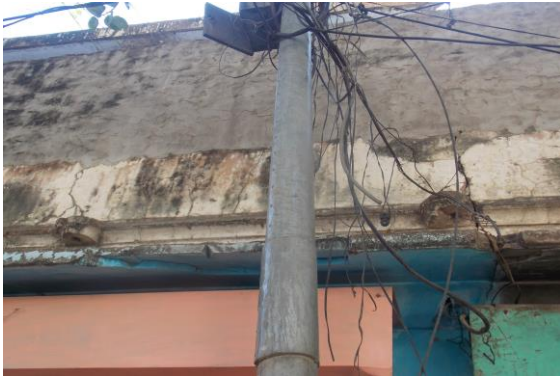
Photo 239

Damaged Portion on Sunshade of Back side, Part C of House No. 2144, Ground Floor

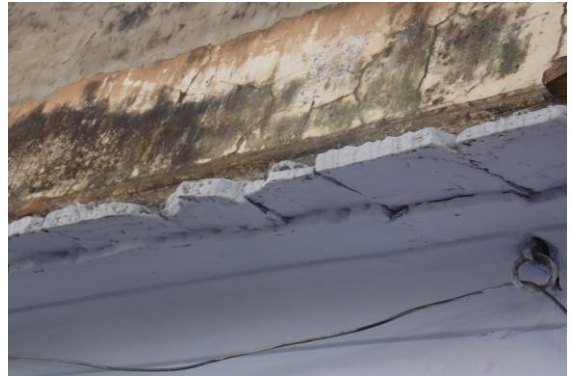
Photo 240

Damaged Portion on Sunshade of Back side, Part C of House No. 2144, Ground Floor

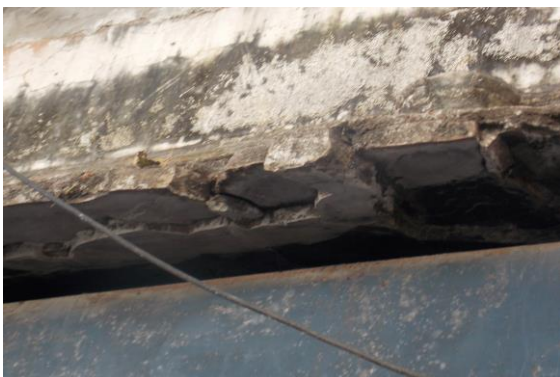
Photo 241

Damaged Portion on Sunshade of Back side, Part C of House No. 2144, Ground Floor

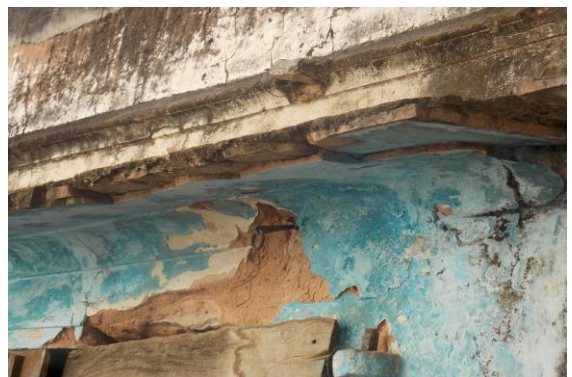
Photo 242

Damaged Portion on Sunshade of Back side, Part C of House No. 2144, Ground Floor

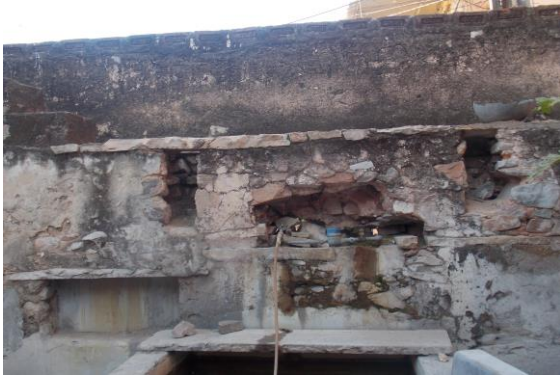
Photo 243

Peeling of Plaster on Wall No. 1 of Back side, Open Sky, Part B of House No. 2144, Ground Floor

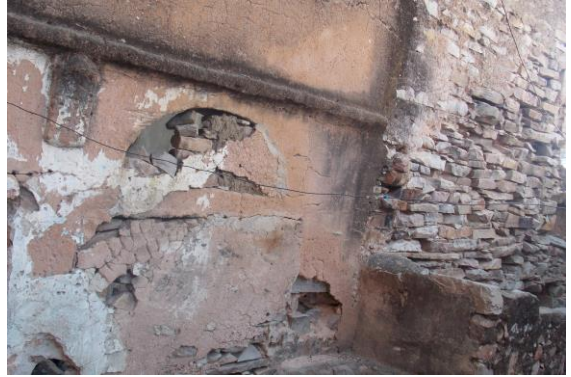
Photo 244

Peeling of Plaster on Wall No. 5 of Back side, Open Sky, Part B of House No. 2144, Ground Floor

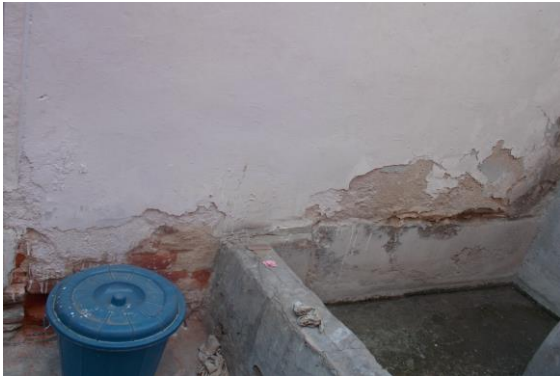
Photo 245

Peeling of Plaster on Wall No. 3 of Back side, Open Sky, Part B of House No. 2144, Ground Floor

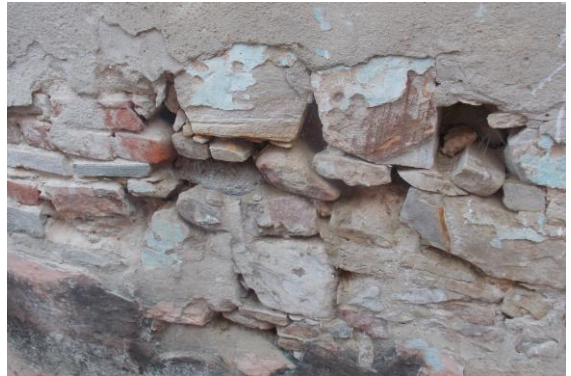
Photo 246

Peeling of Plaster on Wall No. 6 of Back side, Open Sky, Part B of House No. 2144, Ground Floor

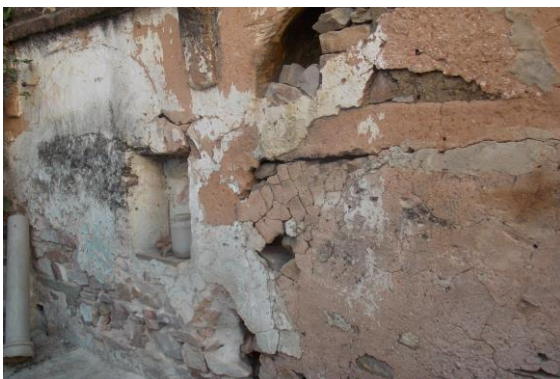
Photo 247

Peeling of Plaster on Wall No. 2 of Back side, Open Sky, Part B of House No. 2144, Ground Floor

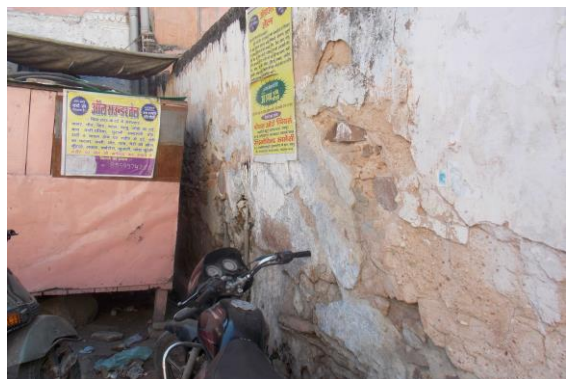
Photo 248

Peeling of Plaster on Left Wall of Back side, Part B of House No. 2144, Ground Floor

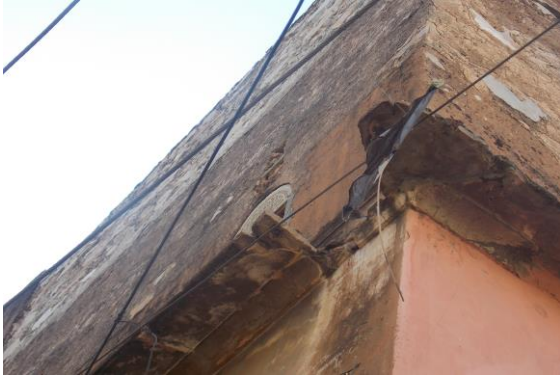
Photo 249

Damaged Portion on Sunshade of Back side, Part B of House No. 2144, Ground Floor

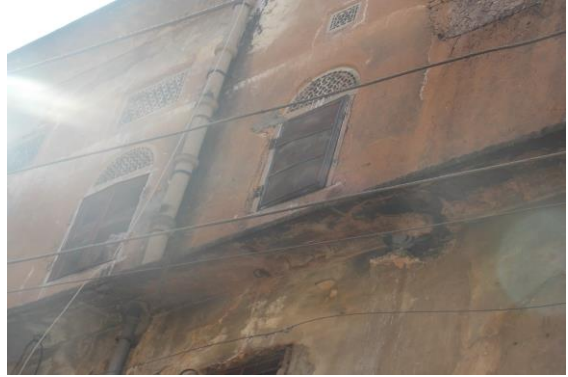
Photo 250

Damaged Portion on Sunshade of Back side, Part B of House No. 2144, Ground Floor

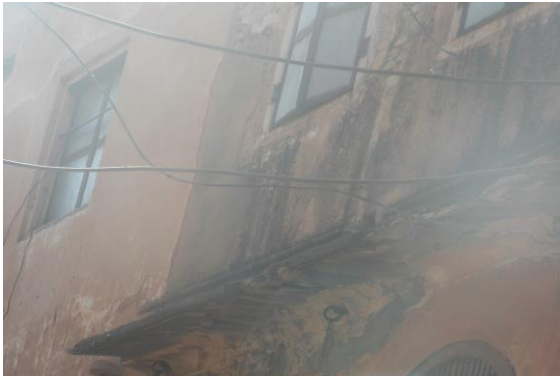
Photo 251

Damaged Portion on Sunshade of Back side, Part B of House No. 2144, Ground Floor

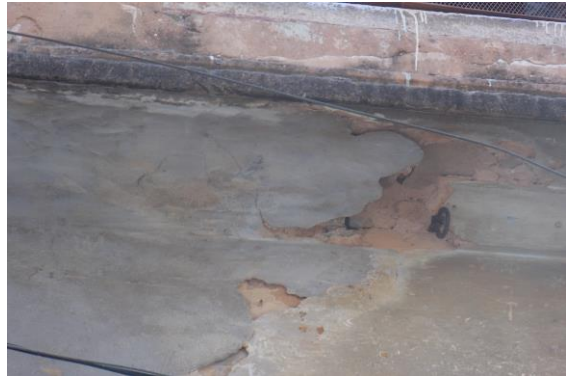
Photo 252

Damaged Portion on Sunshade of Back side, Part B of House No. 2144, Ground Floor

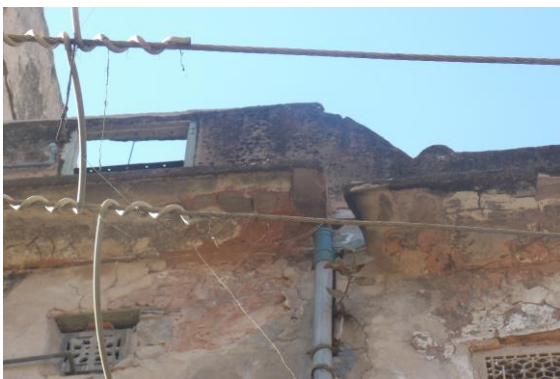
Photo 253

Damaged Portion on Sunshade of Back side, Part B of House No. 2144, First Floor

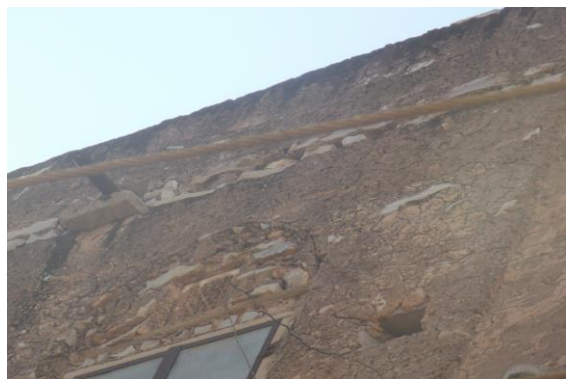
Photo 254

Damaged Portion on Sunshade of Back side, Part B of House No. 2144, First Floor

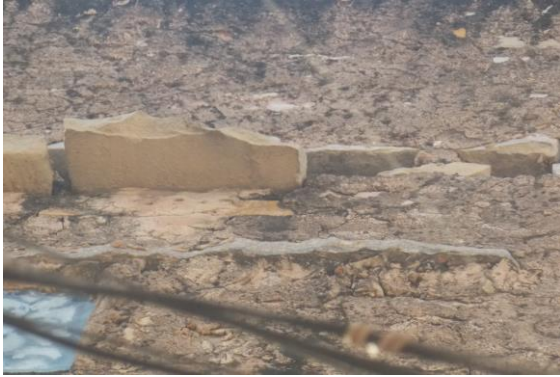
Photo 255

Damaged Portion on Sunshade of Back side, Part B of House No. 2144, First Floor

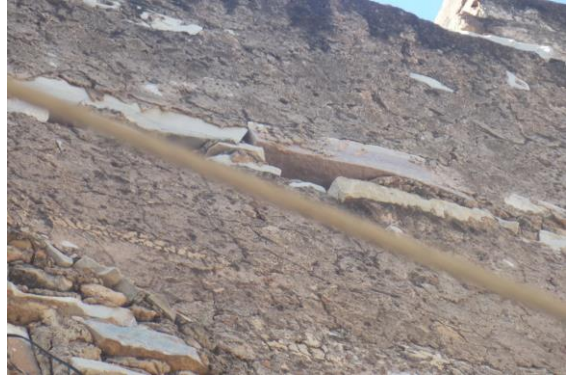
Photo 256

Peeling of Plaster on Left Wall of Temple, Part B of House No. 2144, Second Floor

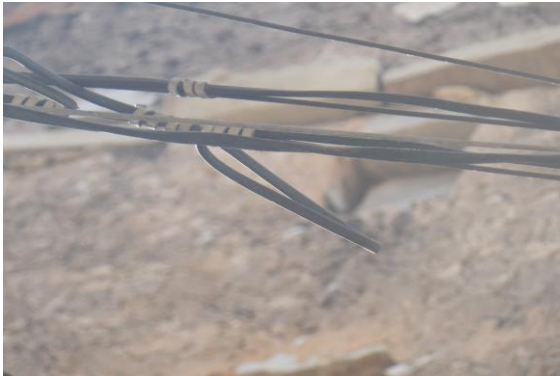
Photo 257

Peeling of Plaster on Left Wall of Temple, Part B of House No. 2144, Second Floor

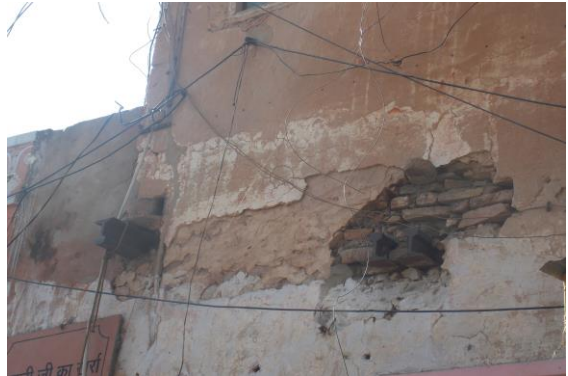
Photo 258

Peeling of Plaster on External Wall of House No. 2144, Second Floor

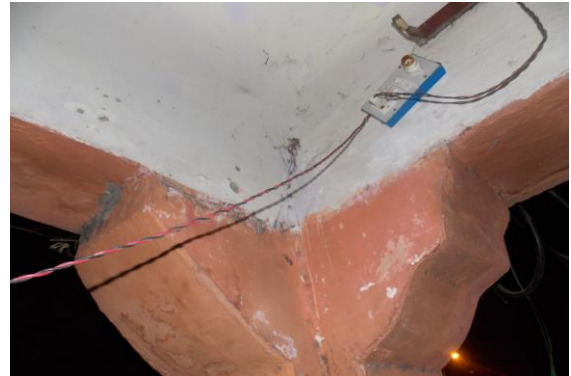
Photo 14  
Horizontal Crack on L/s External Column of Varanda of Shop no.314, G/F Approx. Width = 0.8mm, Approx. Length = 0.6m.

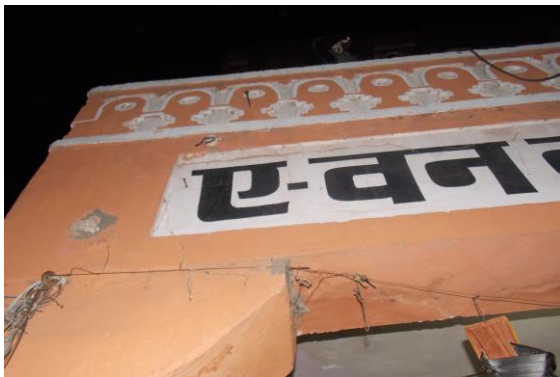
Photo 15  
Inclined Crack on External L/s Column & Beam of Varanda of Shop no.314, Ground Floor Approx. Width = 0.8mm, Approx. Length = 1.5m. Dist. from L/s Wall = 0.3m, Height from Floor = 3m.

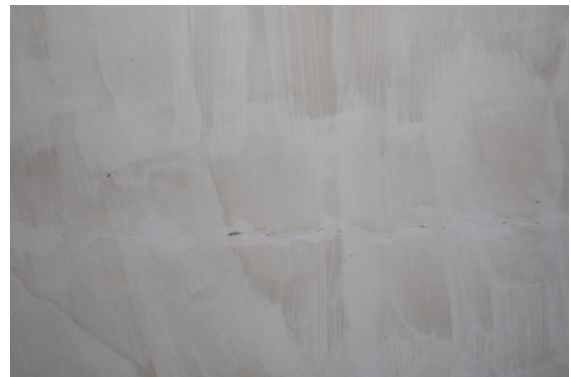
Photo 16  
Horizontal Crack on Roof of Varanda of shop No.313, Ground Floor Approx. Width = 0.35mm, Approx. Length = 2m. Distance from Leftside External Column = 0.4m, Height from Floor = 3.5m.

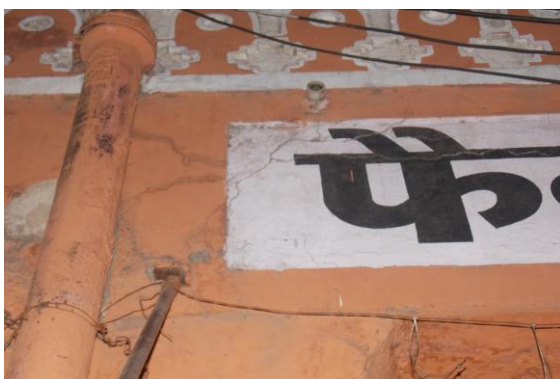
Photo 17  
Inclined Crack on L/s External Column of Varanda of shop No.313, G/F Approx. Width = 0.5mm, Approx. Length = 1.5m. Distance from = Front of L/s External column, Height from Floor = 3m.

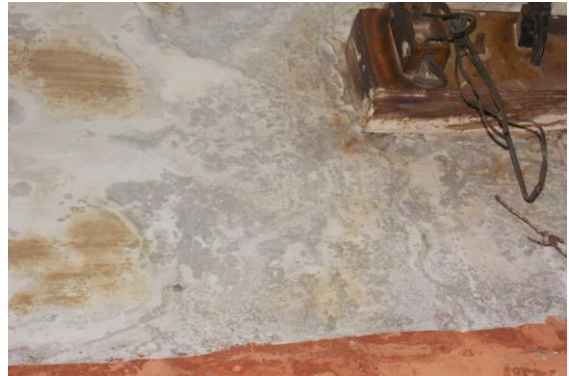
Photo 20

Dampness/Seepage on Leftside External Column of Varanda of shop No.313 of Ground Floor

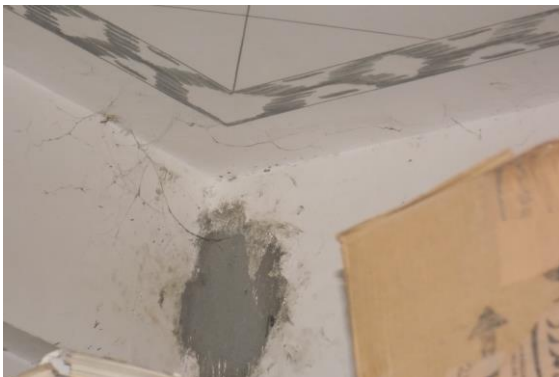
Photo 21

Peeling of Plaster on Wall No. 2 & 3 of Room No. 1 of House No. 2445 First Floor

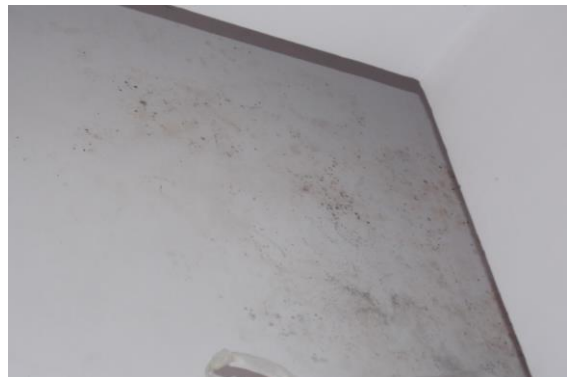
Photo 22

Dampness/Seepage on Wall No. 2 of Room No. 3 of House No. 2445 Second Floor

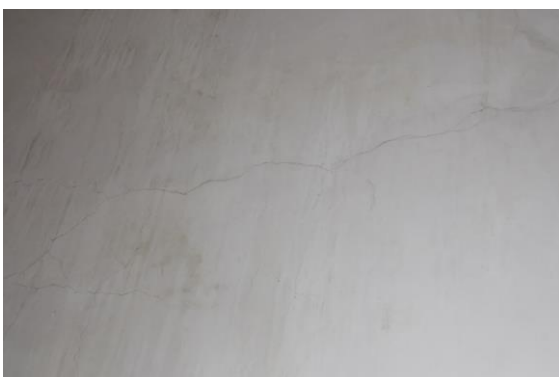
Photo 23

Plaster Crack on Wall No. 2 of Room No. 3 of House No. 2445 Third Floor

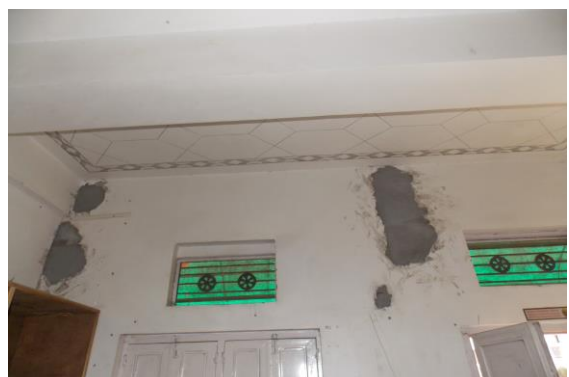
Photo 24

Peeling of Plaster on Wall No. 3 of Room No. 2 of House No. 2445 First Floor

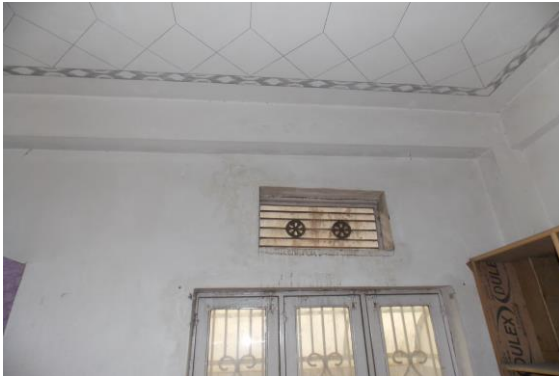
Photo 25  
Dampness/Seepage on Wall No. 4 of Room No. 2 of

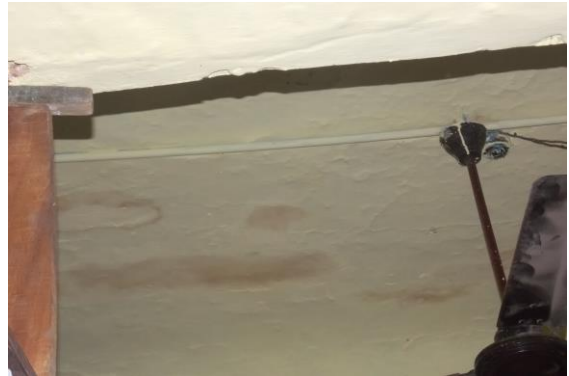
Photo 26  
Dampness/Seepage on Roof of Shop Aggarwal Chai Bhandar of Ground Floor

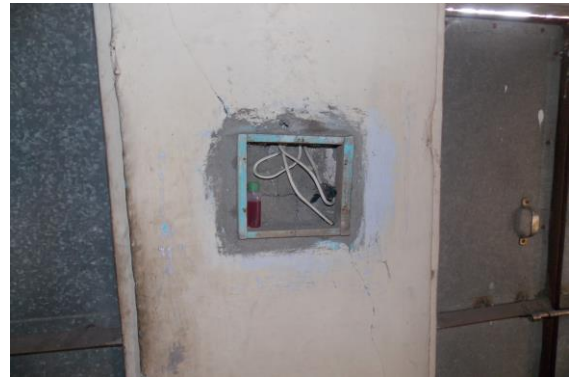
Photo 2

Inclined Crack on Wall No. 4 of Varanda No.1, Second Floor  
Approx. Width = 1.5mm, Approx. Length = 1.1m.  
Distance from Wall No.1 = 0.4m, Height from Floor = 1.3m.

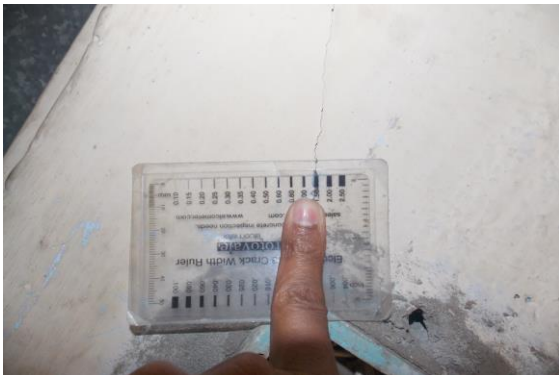
Photo 2A

Inclined Crack on Wall No. 4 of Varanda No.1, Second Floor  
Approx. Width = 1.5mm, Approx. Length = 1.1m.  
Distance from Wall No.1 = 0.4m, Height from Floor = 1.3m.

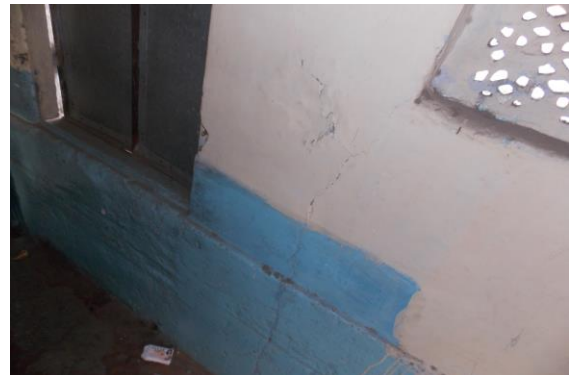
Photo 3

Inclined Crack on Wall No. 4 of Varanda No.1, Second Floor  
Approx. Width = 0.6mm, Approx. Length = 1.8m.  
Distance from Wall No.1 = 3.4m, Height from Floor = 0m.

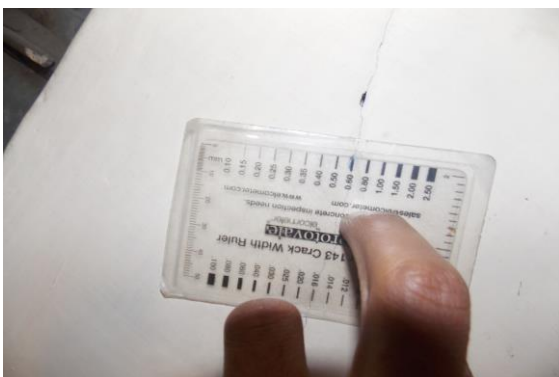
Photo 3A

Inclined Crack on Wall No. 4 of Varanda No.1, Second Floor  
Approx. Width = 0.6mm, Approx. Length = 1.8m.  
Distance from Wall No.1 = 3.4m, Height from Floor = 0m.

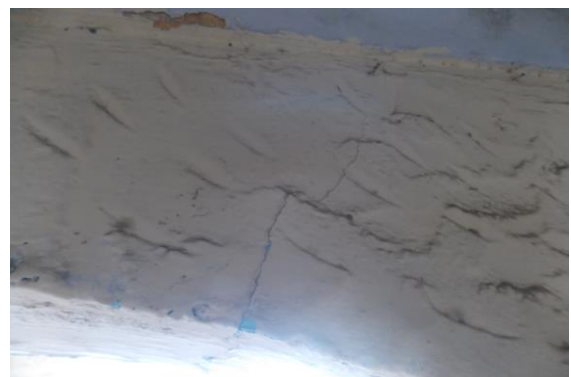
Photo 4

Inclined Crack on Wall No. 3 of Varanda No.1, Second Floor  
Approx. Width = 0.8mm, Approx. Length = 1.4m.  
Distance from Wall No.2 = 1.5m, Height from Floor = 2m.

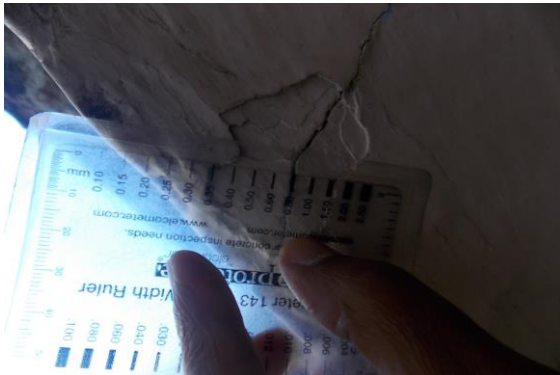
**Photo 4A**

Inclined Crack on Wall No. 3 of Varanda No.1, Second Floor  
Approx. Width = 0.8mm, Approx. Length = 1.4m.  
Distance from Wall No.2 = 1.5m, Height from Floor = 2m.

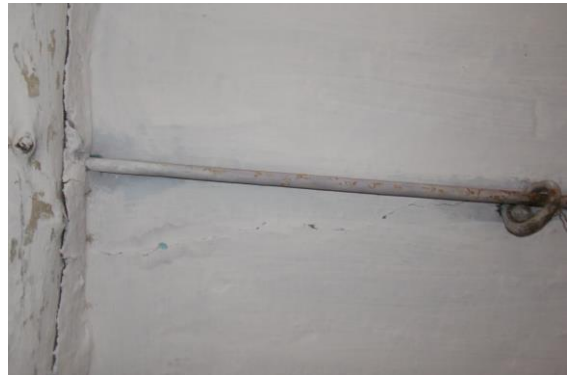
**Photo 5**

Horizontal Crack on Roof of Varanda No.2, Second Floor  
Approx. Width = 0.8mm, Approx. Length = 2.7m.  
Distance from Wall No.3 = 1.7m, Height from Floor = 2.5m.

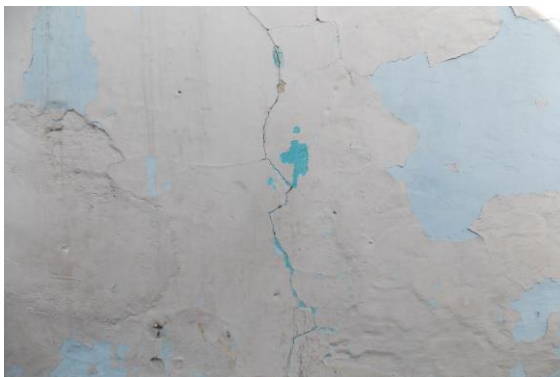
**Photo 7**

Inclined Crack on Wall No. 1 of Open Sky, Second Floor  
Approx. Width = 1mm, Approx. Length = 3m.  
Distance from Wall No.4 = 1m, Height from Floor = 0m.

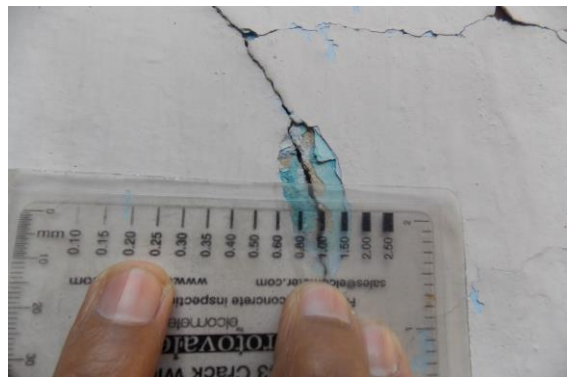
**Photo 7A**

Inclined Crack on Wall No. 1 of Open Sky, Second Floor  
Approx. Width = 1mm, Approx. Length = 3m.  
Distance from Wall No.4 = 1m, Height from Floor = 0m.

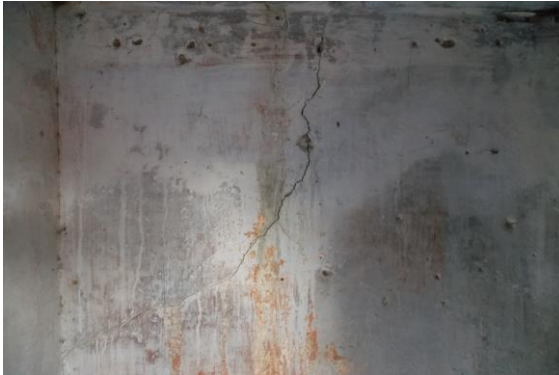
Photo 8

Inclined Crack on Wall No. 4 of Bathroom of House Above Shop No.309 to 311, Third Floor

Approx. Width = 1mm, Approx. Length = 1m.

Distance from Wall No 1 = 0.5m Height from Floor = 2m

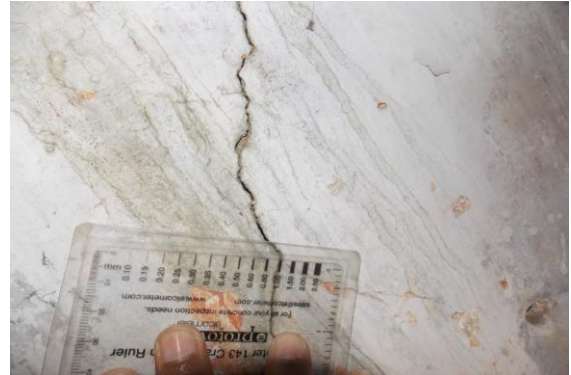
Photo 8A

Inclined Crack on Wall No. 4 of Bathroom No. of House Above Shop No.309 to 311, Third Floor

Approx. Width = 1mm, Approx. Length = 1m.

Distance from Wall No 1 = 0.5m Height from Floor = 2m

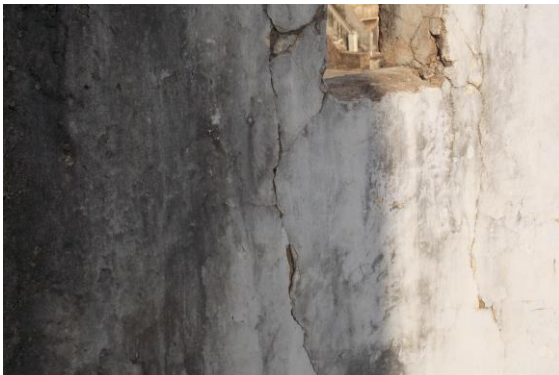
Photo 9

Inclined Crack on Wall No. 1 of open Sky, Third Floor

Approx. Width = 1.5mm, Approx. Length = 1.5m.

Distance from Wall No.3 = 2m, Height from Floor = 0m.

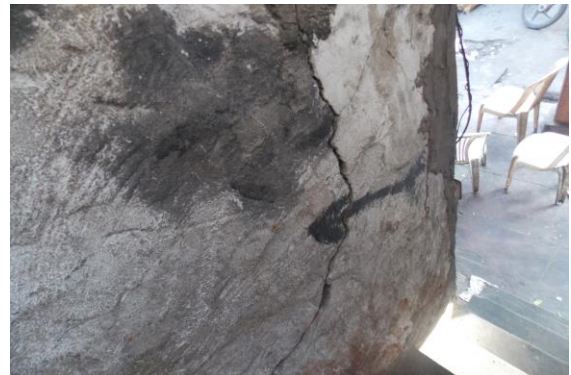
Photo 10

Summary of Cracks						
Defect ID	Location	Orientation	Appx. Width (mm)	Appx. Length (m)	Category	Photo No.
1	Wall No. 4 Varanda No.1 Second Floor	Inclined	1.5	1.1	Slight	2, 2A
2	Wall No. 4 Varanda No.1 Second Floor	Inclined	0.6	1.8	Very Slight	3, 3A
3	Wall No. 3 Varanda No.1 Second Floor	Inclined	0.8	1.4	Very Slight	4, 4A
4	Roof Varanda No.2 Second Floor	Horizontal	0.8	2.7	Very Slight	5
5	Wall No. 2 Room No. 1 House Above Shop No.309 to 311, Second Floor	Inclined	0.8	1.1	Very Slight	6, 6A
6	Wall No. 1 Open Sky Second Floor	Inclined	1	3	Slight	7, 7A
7	Wall No. 4 Bathroom House Above Shop No.309 to 311, Third Floor	Inclined	1	1	Slight	8, 8A
8	Wall No. 1 open Sky Third Floor	Inclined	1.5	1.5	Slight	9
9	Wall No. 2 Staircase Ground Floor to First Floor	Inclined	25	2	Very Severe	10, 10A

Inclined Crack on Wall No. 2 of Staircase Ground Floor to First Floor

Approx. Width = 25mm, Approx. Length = 2m.

Distance from Wall No.3 = 0.3m, Height from Floor = 0m.

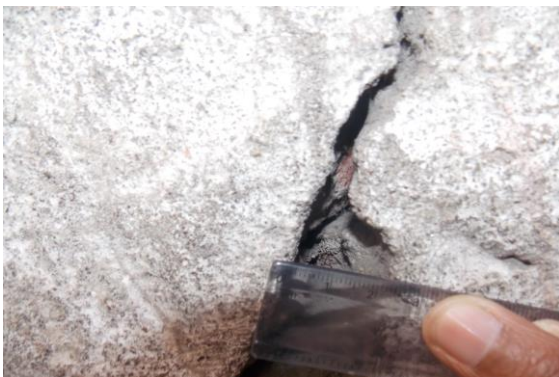
Photo 10A

Inclined Crack on Wall No. 2 of Staircase Ground Floor to First Floor

Approx. Width = 25mm, Approx. Length = 2m.

Distance from Wall No.3 = 0.3m, Height from Floor = 0m.

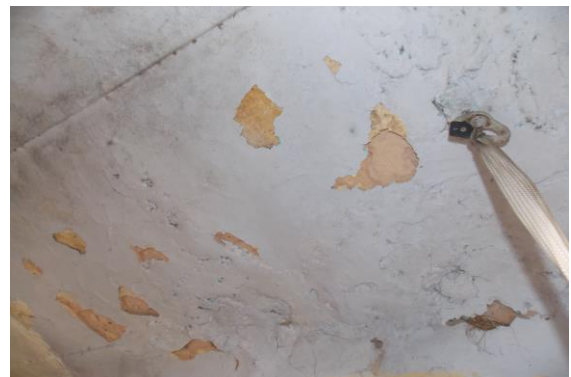
Photo 11

Peeling of Plaster on Roof of Varanda No.1 of Second Floor

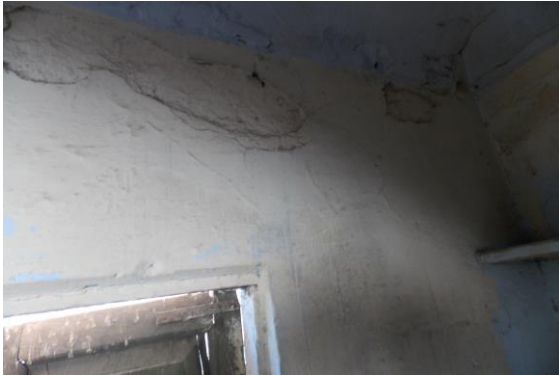
Photo 12

Peeling of Plaster on Wall No. 4 of Varanda No.1 of Second Floor

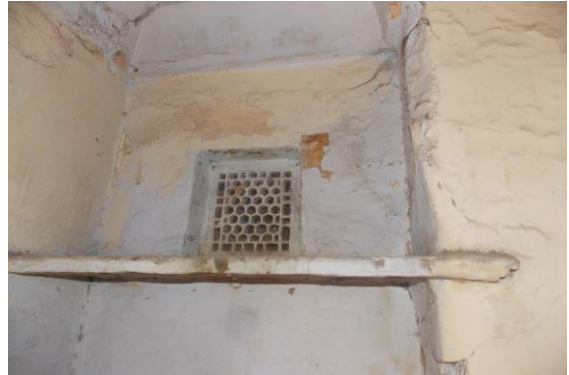
Photo 13

Peeling of Plaster on Wall No. 2 of Varanda No.1 of Second Floor

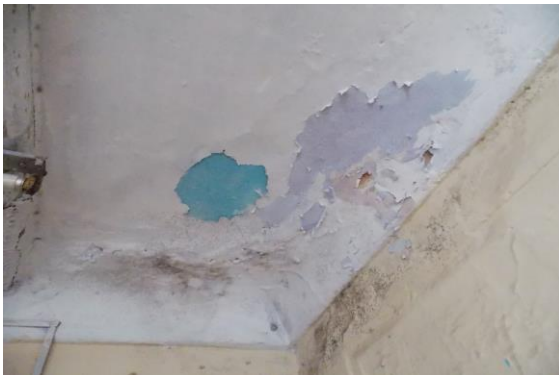
Photo 14

Dampness/Seepage on Wall No. 2 & 4, Roof of Varanda No.2 of Second Floor

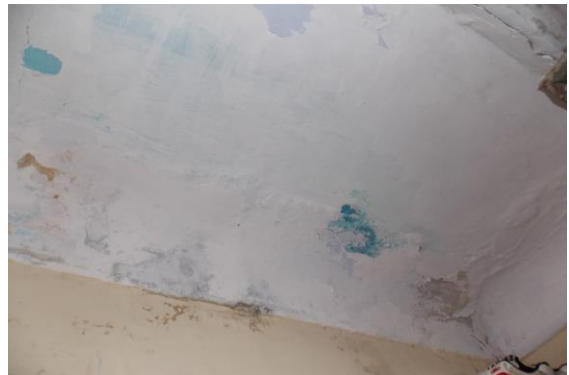
Photo 15

Dampness/Seepage on Wall No. 1 & Roof of Varanda No.2 of Second Floor

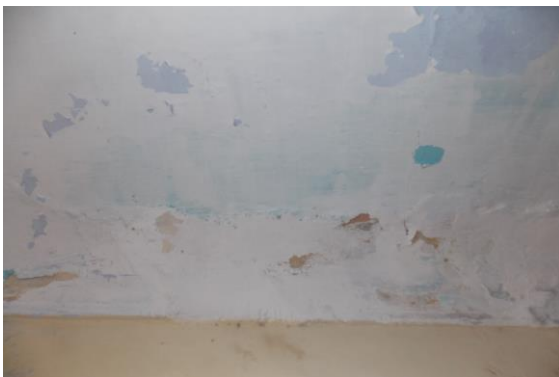
Photo 16

Peeling of Plaster on Wall No. 1 of Varanda No.2 of Second Floor

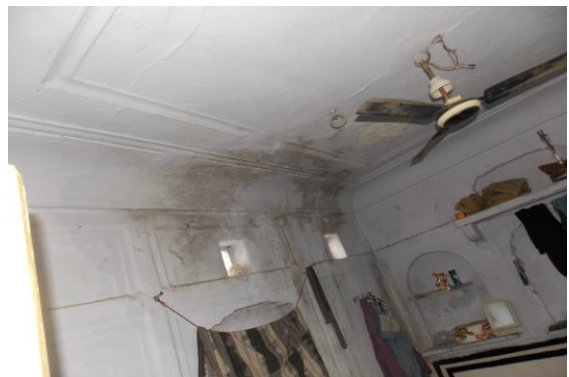
Photo 17

Dampness/Seepage on Wall No. 1 & Roof of Room No. 1 of House Above Shop No.309 to 311, Second Floor
