### Pre Building Condition Survey Report

Name and Address of Structure :	Badi Chopar to Ramp Area (UP Line)
---------------------------------	------------------------------------

Name of the Project	<b>Contract JMRC-UG1B</b> “Design and Construction of Tunnel between Chandpole and Badi Chouper and reverse line by Shield TBM, Underground Metro Stations at Choti Chouper and Badi Chouper by Cut and Cover Methods on East West Corridor of Jaipur Metro Rail Corporation Limited .”	
Owner :

Pre Building Condition Survey Report Badi Chopar to Ramp Area (UP Line)

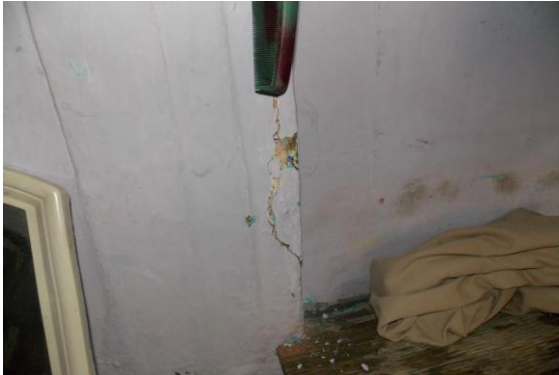
Photo 18

Peeling of Plaster on Wall No. 4 of Room No. 1 of House Above Shop No.309 to 311, Second Floor

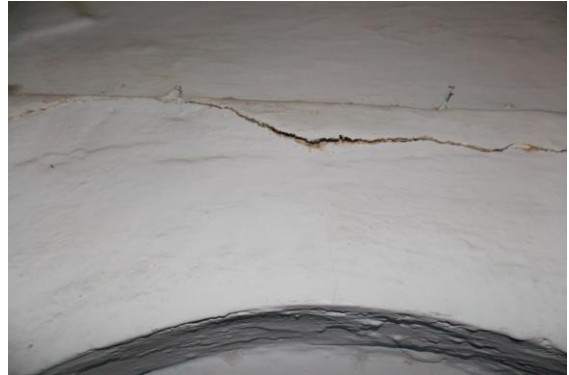
Photo 19

Peeling of Plaster on Wall No. 4 of Room No. 1 of House Above Shop No.309 to 311, Second Floor

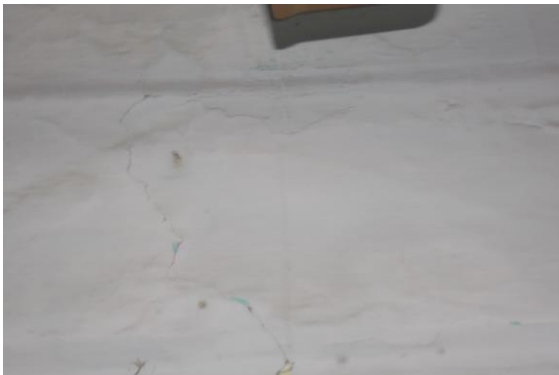
Photo 20

Peeling of Plaster on Wall No. 2 of Room No. 1 of House Above Shop No.309 to 311, Second Floor

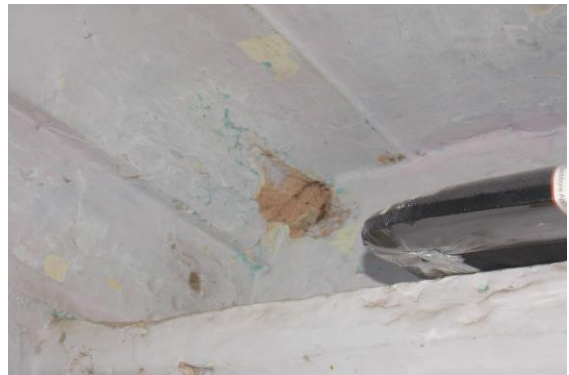
Photo 21

Peeling of Plaster on Wall No. 3 of Room No. 1 of House Above Shop No.309 to 311, Second Floor

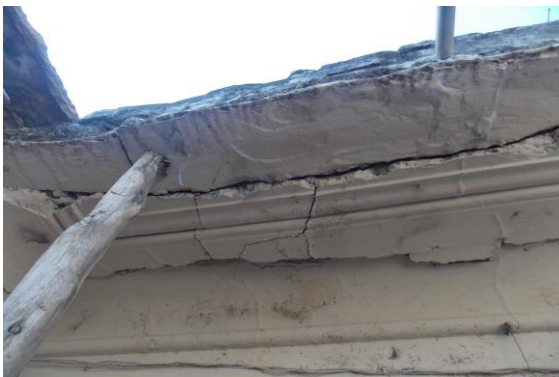
Photo 22

Damaged Portion on Wall No. 3 of Sunshade of Second Floor

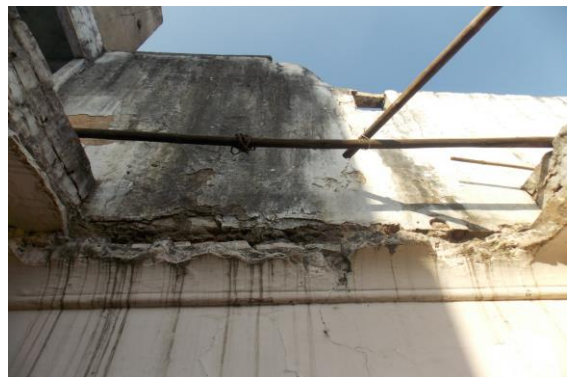
Photo 23

Damaged Portion on Wall No. 1 of Sunshade of Second Floor

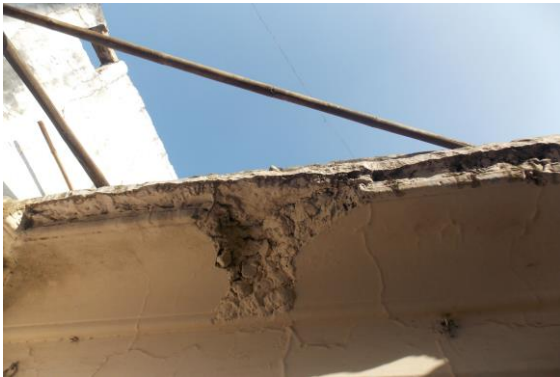
Photo 24  
Peeling of Plaster on Wall No. 4 of Open Sky of Second Floor

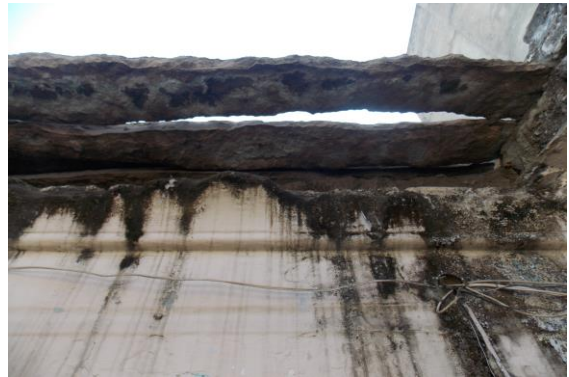
Photo 25  
Peeling of Plaster on Wall No. 2 of Open Sky of Second Floor

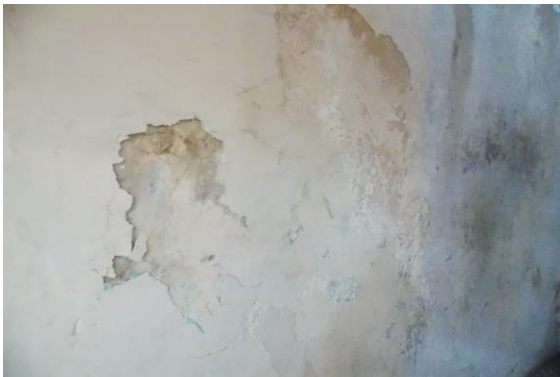
Photo 26  
Peeling of Plaster on Wall No. 1 of Staircase Second Floor To Third Floor

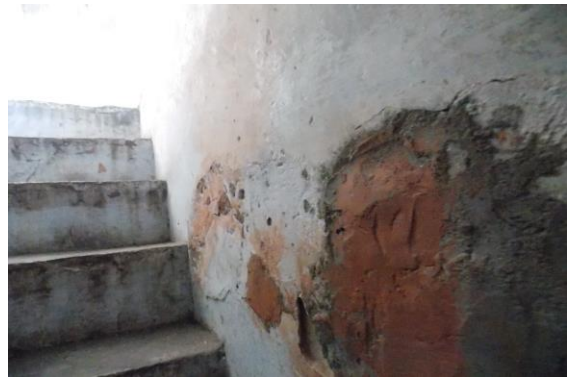
Photo 27  
Peeling of Plaster on Wall No. 2 of Staircase Second Floor To Third Floor

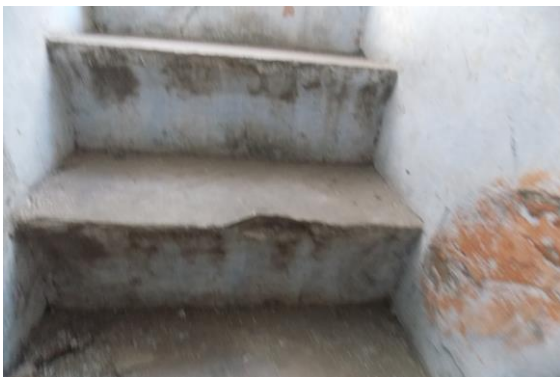
Photo 28  
Peeling of Plaster on Wall No. Steps of Staircase Second Floor To Third Floor

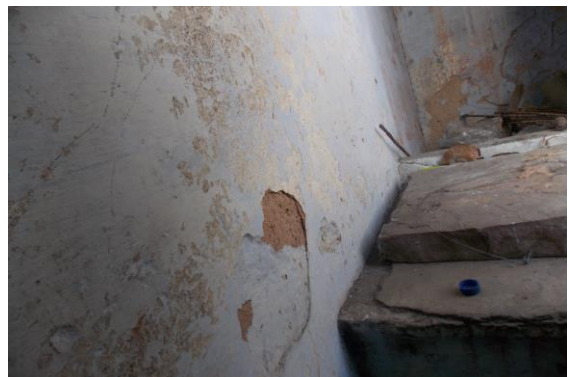
Photo 29  
Peeling of Plaster on Wall No. 1 of Staircase Second Floor To Third Floor

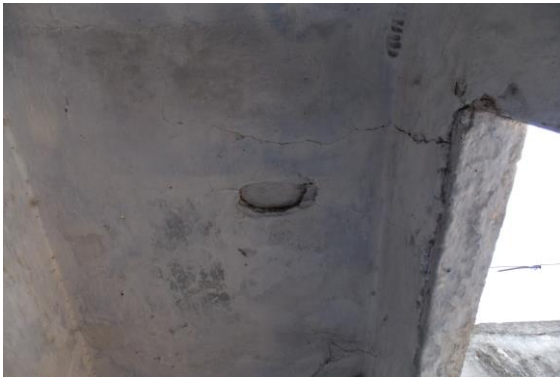
Photo 30

Peeling of Plaster on Roof of Staircase Second Floor To Third Floor

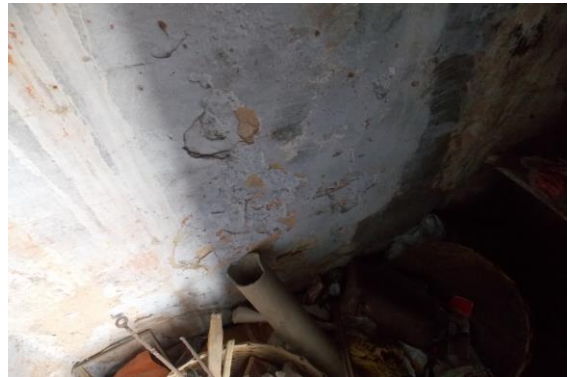
Photo 31

Peeling of Plaster on Wall No. 4 of Bathroom of House Above Shop No.309 to 311, Third Floor

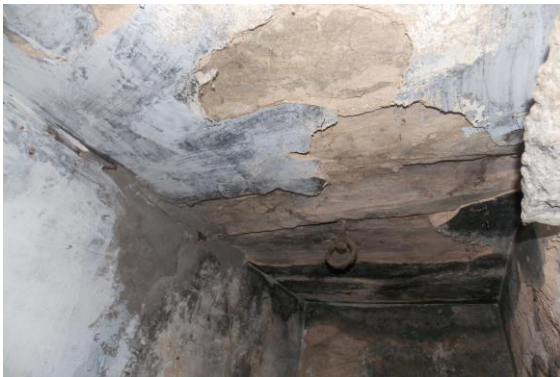
Photo 32

Peeling of Plaster on Roof of Bathroom of House Above Shop No.309 to 311, Third Floor

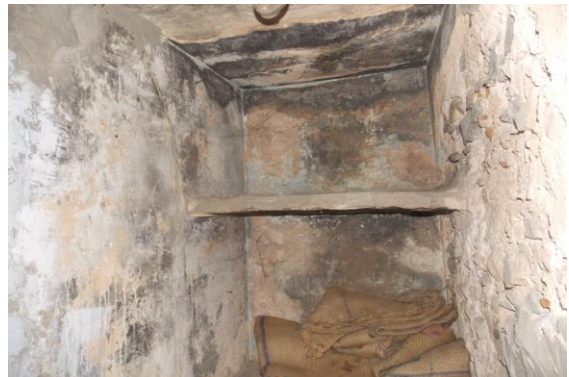
Photo 33

Peeling of Plaster on Wall No. 2 of Bathroom of House Above Shop No.309 to 311, Third Floor

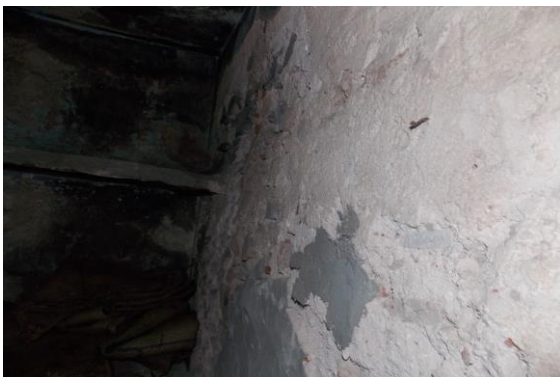
Photo 34

Peeling of Plaster on Wall No. 3 of Bathroom of House Above Shop No.309 to 311, Third Floor

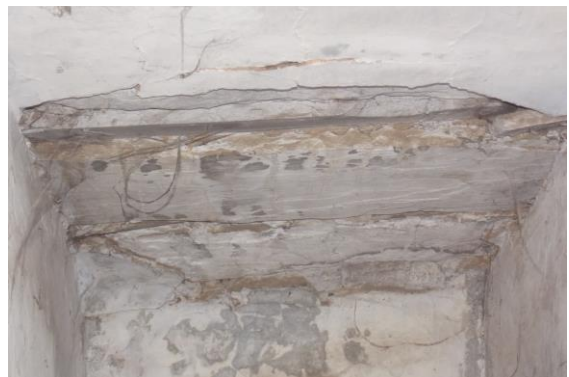
Photo 35

Peeling of Plaster on Roof of Staircase Second Floor to Third Floor

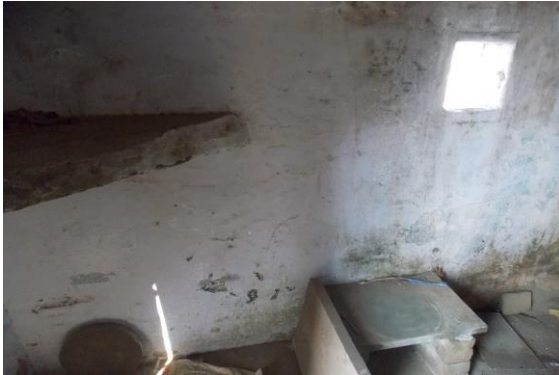
Photo 36

Dampness/Seepage on Wall No. 1 of Room No. 1 of Third Floor

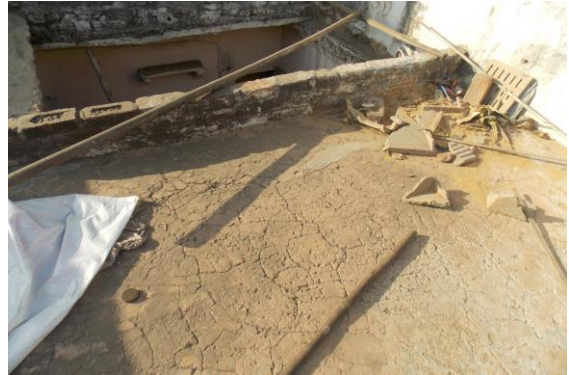
Photo 37

Peeling of Plaster on Floor of Terrace of Third Floor

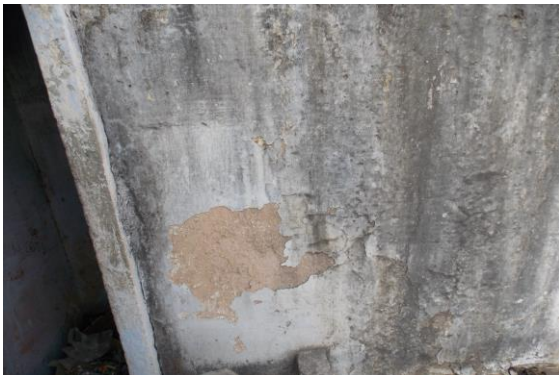
Photo 38

Peeling of Plaster on Wall No. 1 of open Sky of Third Floor

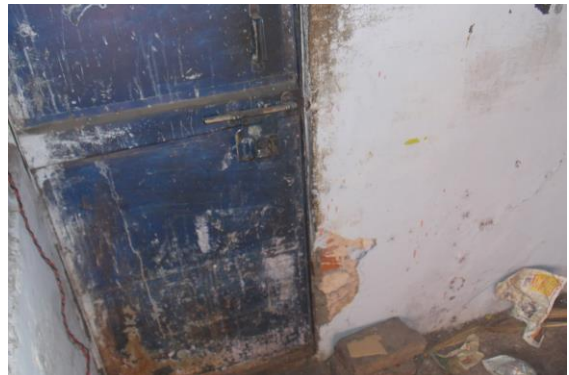
Photo 39

Peeling of Plaster on Wall No. 1 of Room No. 1 of House Above Shop No.309 to 311, First Floor

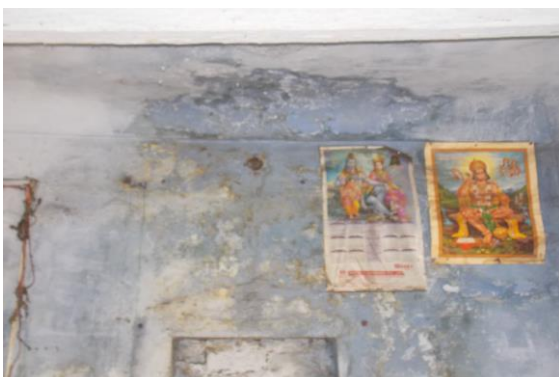
Photo 40

Dampness/Seepage on Wall No. 4 & Roof of Room No. 1 of House Above Shop No.309 to 311, First Floor

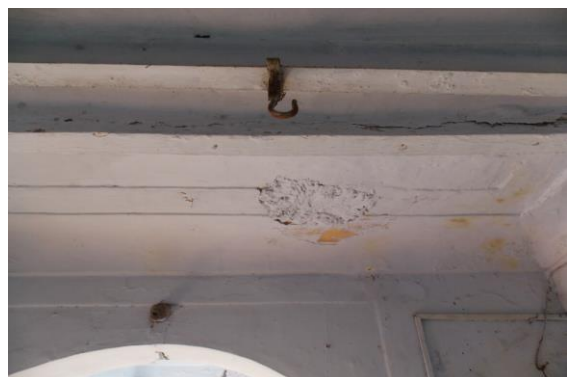
Photo 41

Peeling of Plaster on Roof of Room No. 1 of House Above Shop No.309 to 311, First Floor

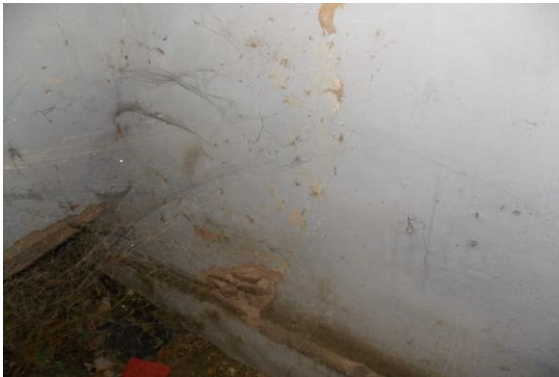
Photo 42

Peeling of Plaster on Wall No. 1 & 4 of Passage of First Floor

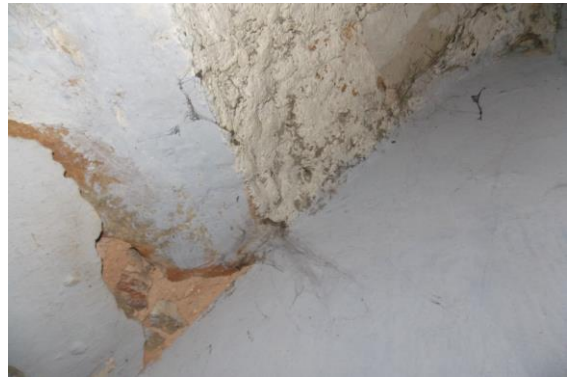
Photo 43

Peeling of Plaster on Roof of Passage of First Floor

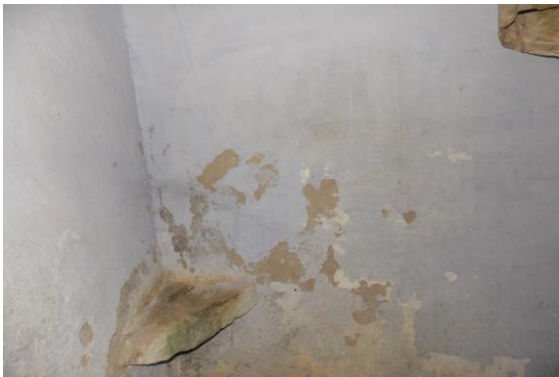
Photo 44

Peeling of Plaster on Wall No. 4 of Bathroom of First Floor

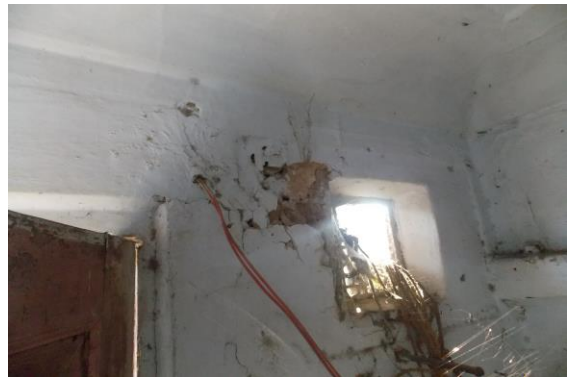
Photo 45

Peeling of Plaster on Wall No. 3 of Varanda of First Floor

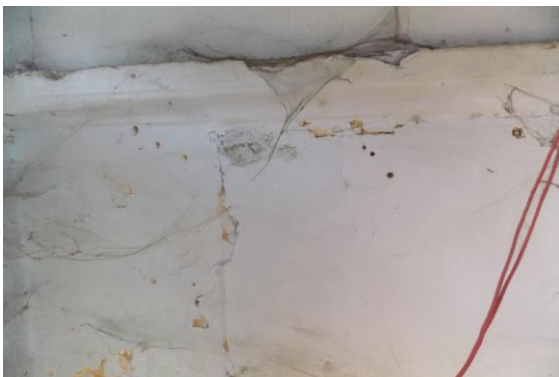
Photo 46

Peeling of Plaster on Wall No. 1 of Varanda of First Floor

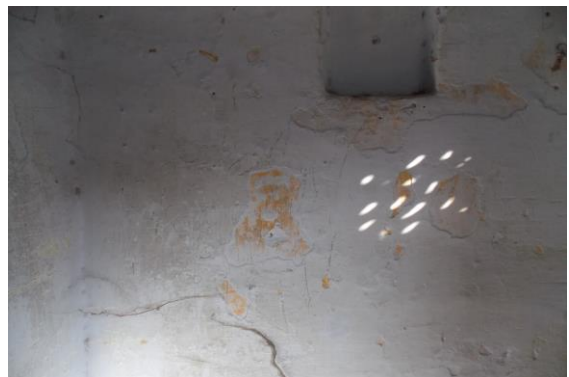
Photo 47

Peeling of Plaster on Wall No. 2 of Varanda of First Floor

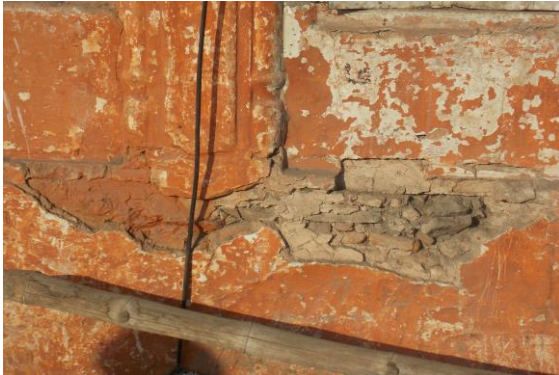
Photo 48  
Peeling of Plaster on Frontside Wall of First Floor

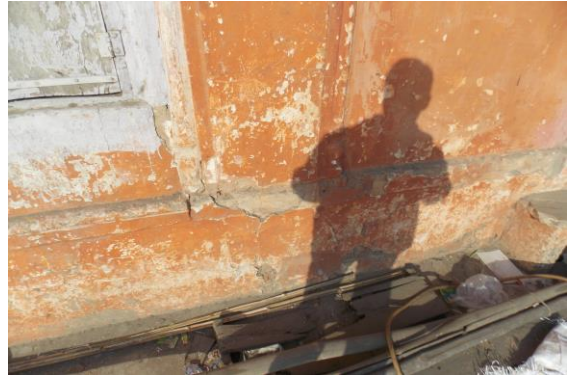
Photo 49  
Peeling of Plaster on Frontside Wall of First Floor

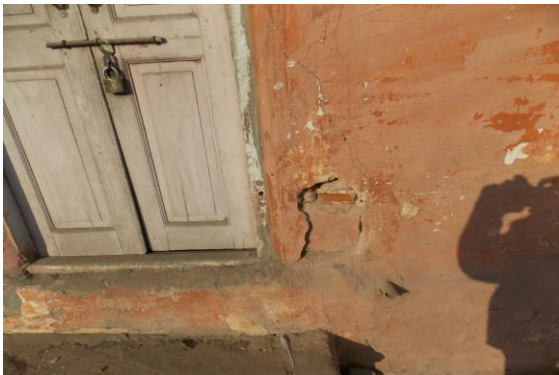
Photo 50  
Peeling of Plaster on Frontside Wall of First Floor

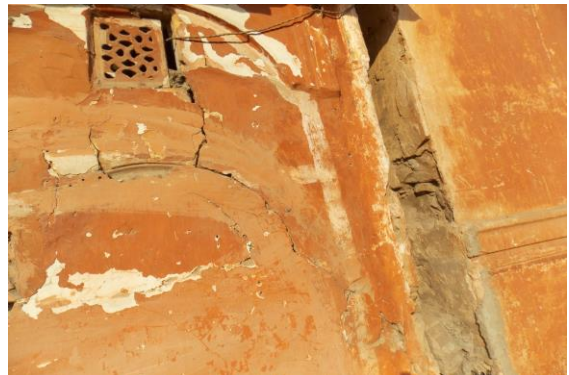
Photo 51  
Damaged Portion on Frontside Wall of First Floor

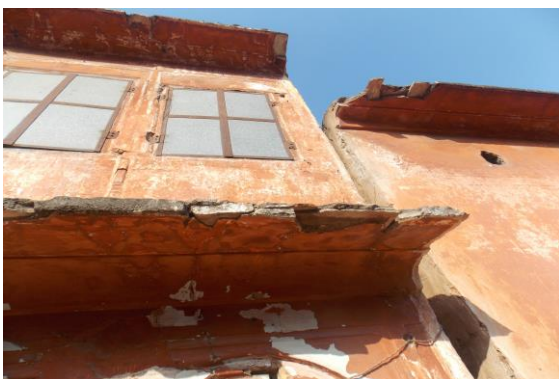
Photo 52  
Damaged Portion on Frontside Wall of Sunshade of First Floor

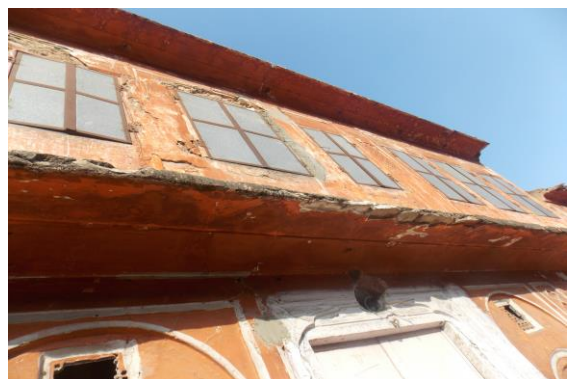
Photo 53  
Damaged Portion on Frontside Wall of Sunshade of First Floor

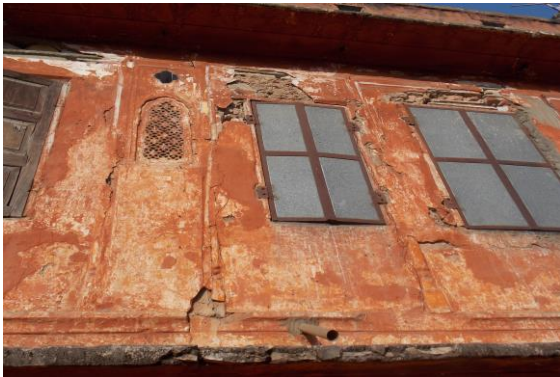
Photo 54  
Peeling of Plaster on Frontside Wall of Second Floor

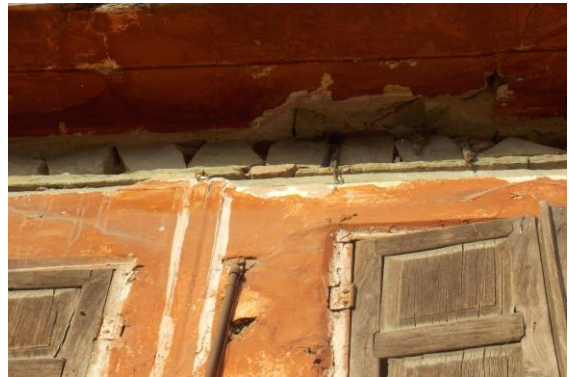
Photo 55  
Peeling of Plaster on Frontside Wall of Second Floor

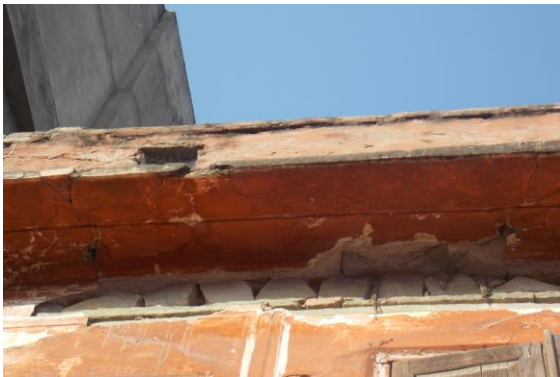
Photo 56  
Damaged Portion on Frontside Wall of Sunshade of Second Floor

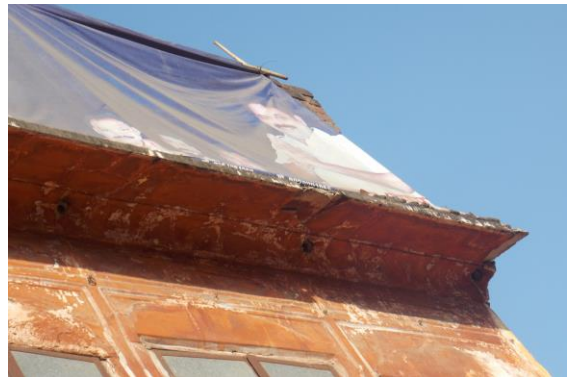
Photo 57  
Damaged Portion on Frontside Wall of Sunshade of Second Floor

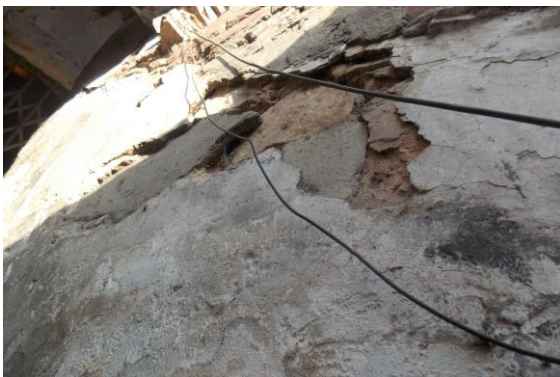
Photo 58  
Peeling of Plaster on Wall No. 2 of Staircase Ground Floor to First Floor

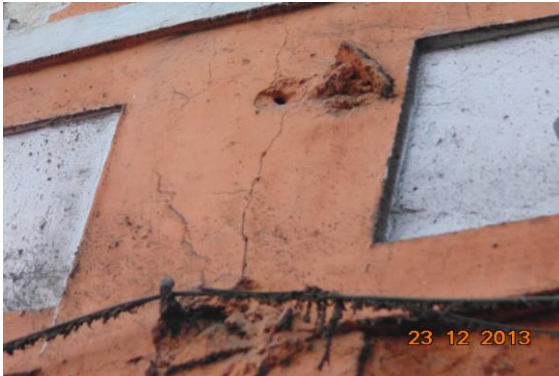
Photo 13

Inclined Crack on Left External Column of Varanda of Shop No.307, Ground Floor Approx. Width = 0.3mm, Approx. Length = 1m. Distance from L.S. Ext. Col = 0m, Height from Floor = 2.5m.

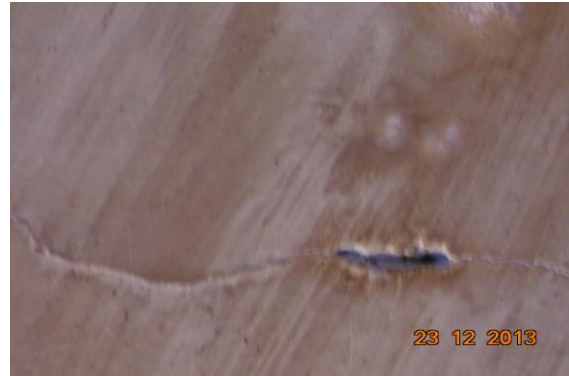
Photo 14

Horizontal Crack on Roof of Varanda of Shop No.307, Ground Floor Approx. Width = 0.4mm, Approx. Length = 2.2m. Distance from Leftside External Column = 0m, Height from Floor = 3m.

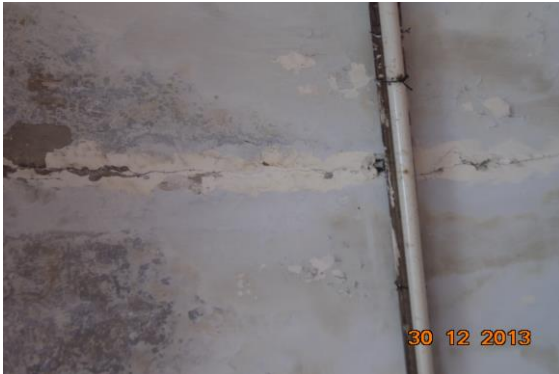
Photo 15

Horizontal Crack on Wall No. 1 of Varanda, Shop No. 300, Ground Floor Approx. Width = 0.4mm, Approx. Length = 2m. Distance from Left Side External Column = 0m, Height from Floor = 3m.

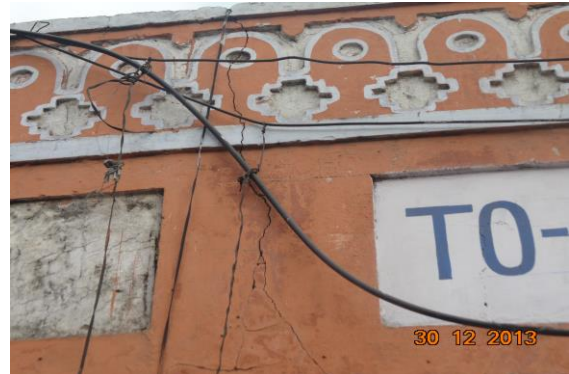
Photo 16

Inclined Crack on Left Side Column of Varanda, Shop No. 300, Ground Floor Approx. Width = 1.5mm, Approx. Length = 1m. Distance from L.S. Ext. Column = 0m, Height from Floor = 2m.

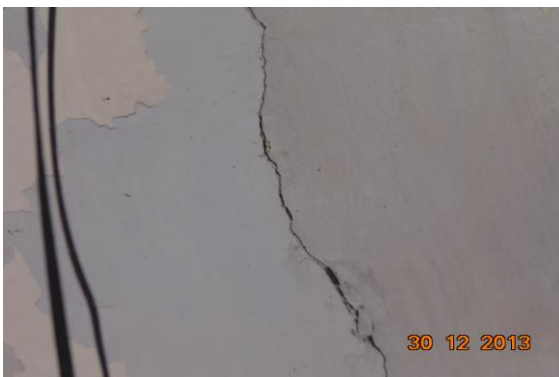
Photo 17

Horizontal Crack on Left Side Column of Varanda, Shop No. 300, Ground Floor Approx. Width = 0.6mm, Approx. Length = 2m. Distance from L.S. Ext Column = 0m, Height from Floor = 3m.

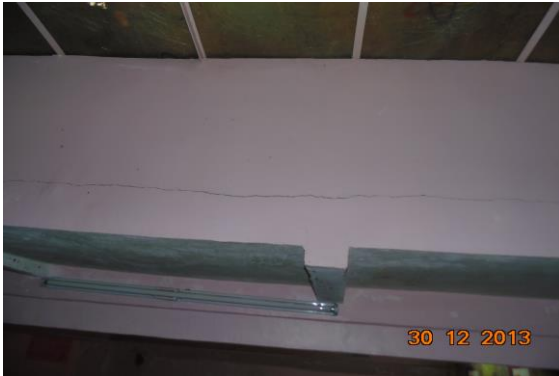
Photo 18

Horizontal Crack on Roof of Hall No. 1, Shop No. 302, Upper Ground Floor Approx. Width = 1mm, Approx. Length = 2.5m. Distance from Wall No.4 = 0m, Height from Floor = 2m.

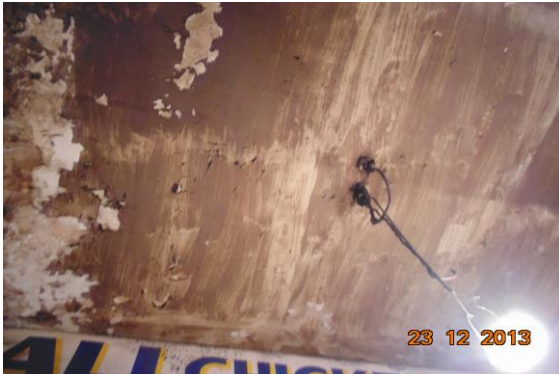
Photo 19

Peeling of Plaster on Roof of Varanda of Shop No.308 of Ground Floor

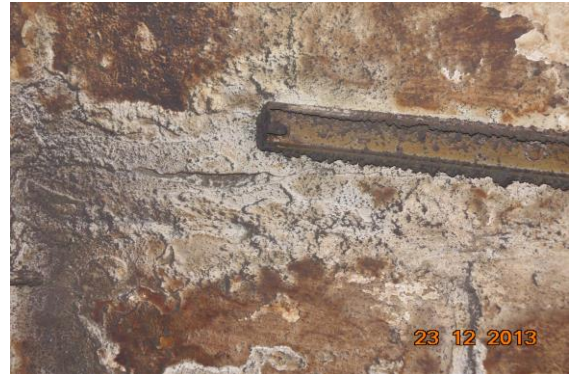
Photo 20

Peeling of Plaster on Roof of Shop No.308 of Ground Floor

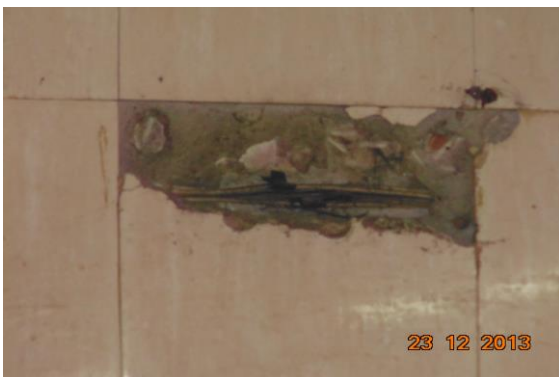
Photo 21

Peeling of Plaster on Wall No. 4 of Shop No.308 of Ground Floor

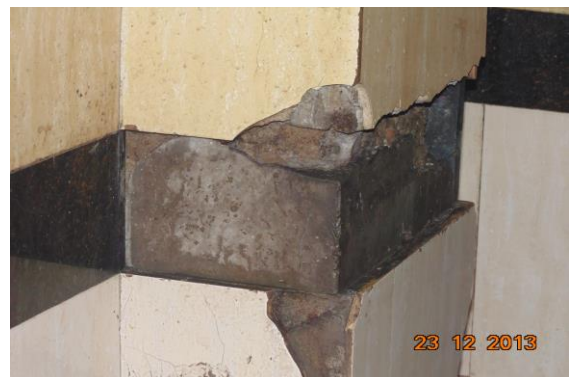
Photo 22

Peeling of Plaster on Wall No. 1 of Shop No.308 of Ground Floor

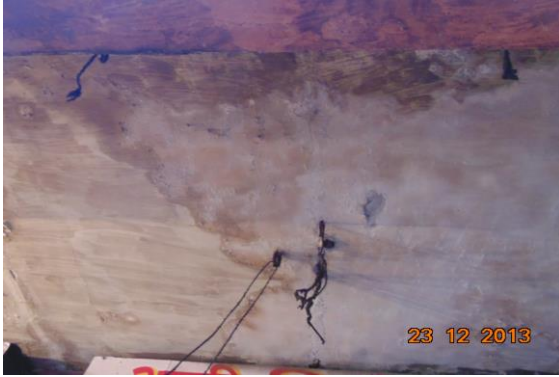
Photo 23

Dampness/Seepage on Roof of Varanda of Shop No.307 of Ground Floor

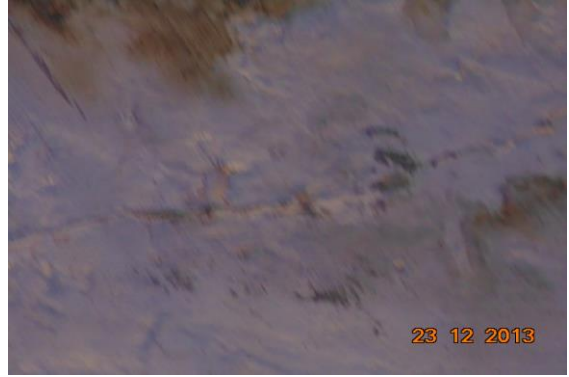
Photo 24

Peeling of Plaster on Roof of Varanda of Shop No.307 of Ground Floor

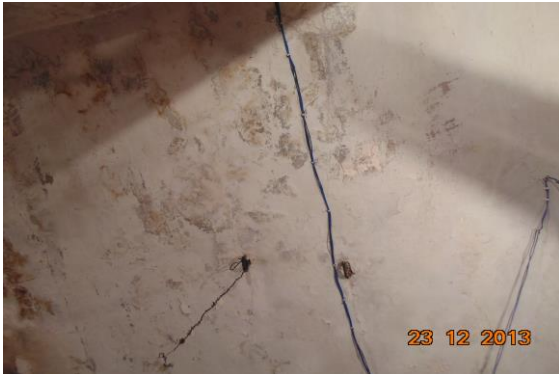
Photo 25

Peeling of Plaster on Roof of Varanda of Shop No.306 of Ground Floor

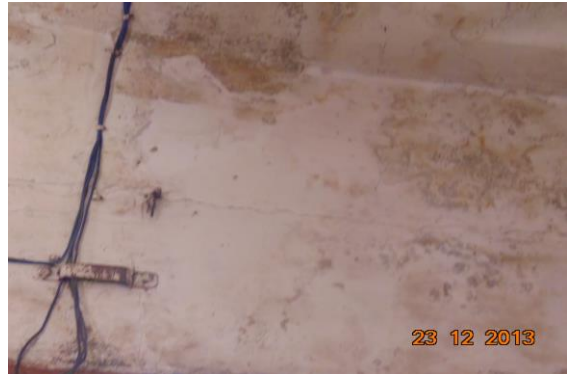
Photo 26

Dampness/Seepage on Beam of Varanda of Shop No.306 of Ground Floor

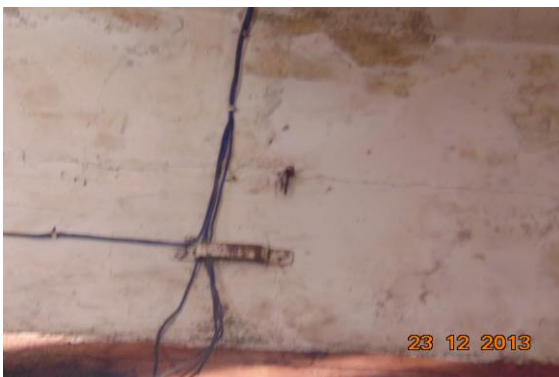
Photo 27

Peeling of Plaster on Beam of Varanda of Shop No.306 of Ground Floor

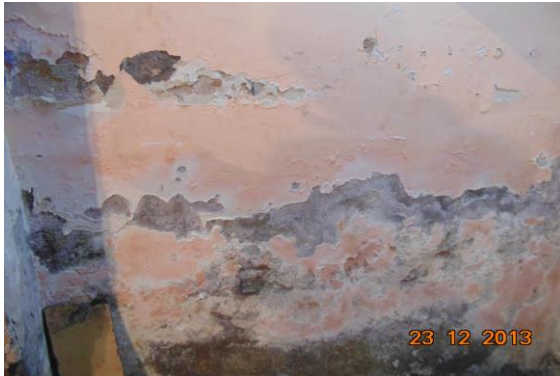
Photo 29

Peeling of Plaster on Wall No. 4 of Part A of Shop No.306 of Ground Floor

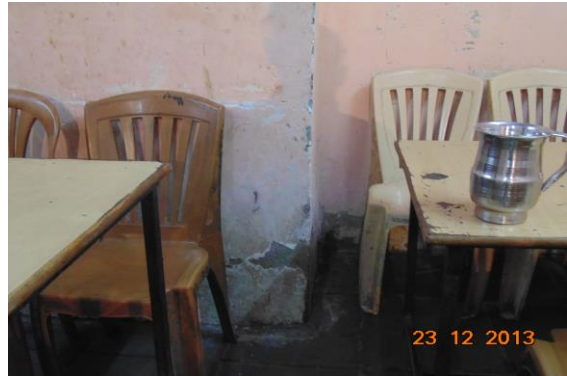
Photo 30

Peeling of Plaster on Wall No. 1 & Roof of Part A of Shop No.306 of Ground Floor

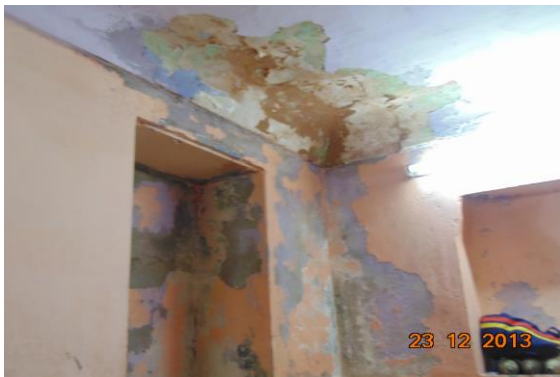
Photo 31

Peeling of Plaster on Wall No. 4 of Part A of Shop No.306 of Ground Floor

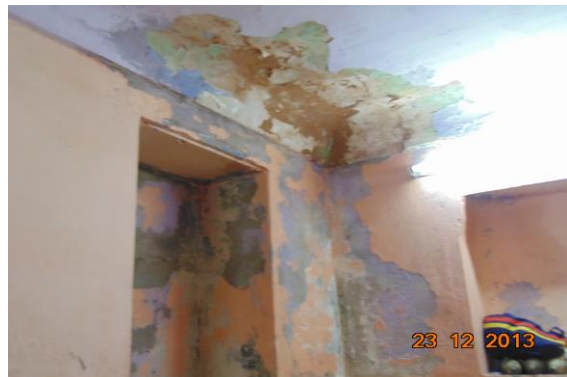
Photo 32

Dampness/Seepage on Wall No. 5, 6 & Roof of Part A of Shop No.306 of Ground Floor

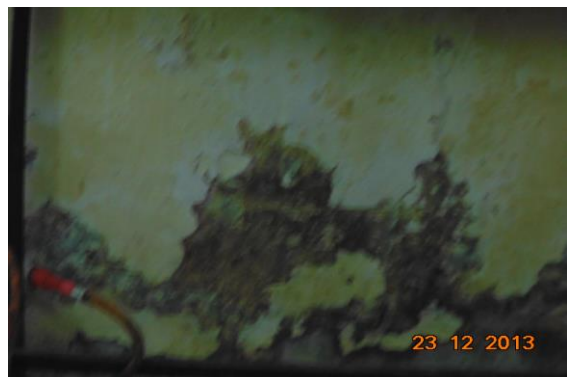
Photo 34

Peeling of Plaster on Wall No. 1 of Part B of Shop No.306 of Ground Floor

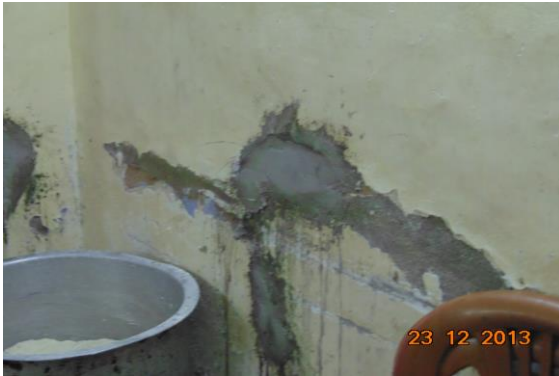
Photo 35

Dampness/Seepage on Wall No. 2 of Part B of Shop No.306 of Ground Floor

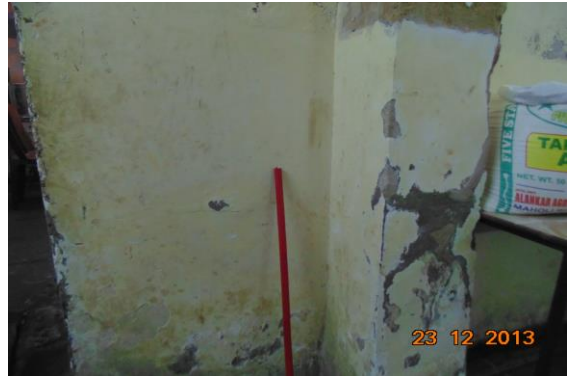
Photo 36

Peeling of Plaster on Wall No. 3 of Part B of Shop No.306 of Ground Floor

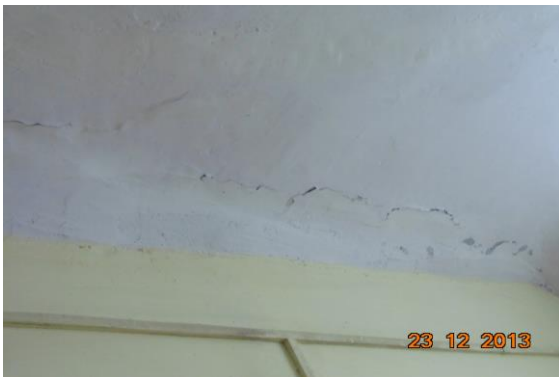
Photo 37

Peeling of Plaster on Roof of Part B of Shop No.306 of Ground Floor

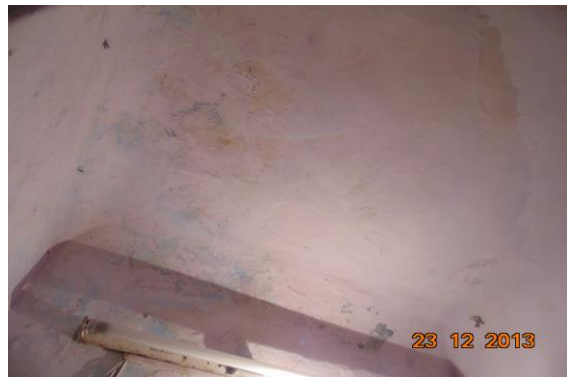
Photo 38

Dampness/Seepage on Roof of Part C of Shop No.306 of Ground Floor

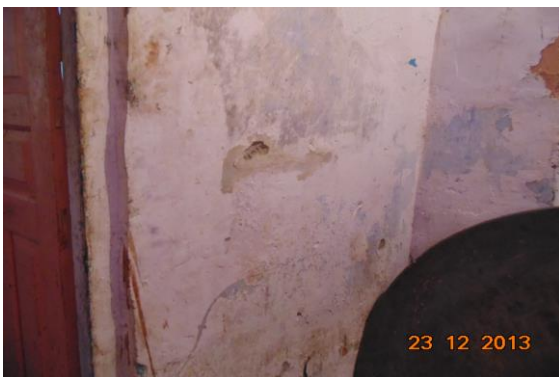
Photo 39

Dampness/Seepage on Wall No. 1 & 3 of Part C of Shop No.306 of Ground Floor

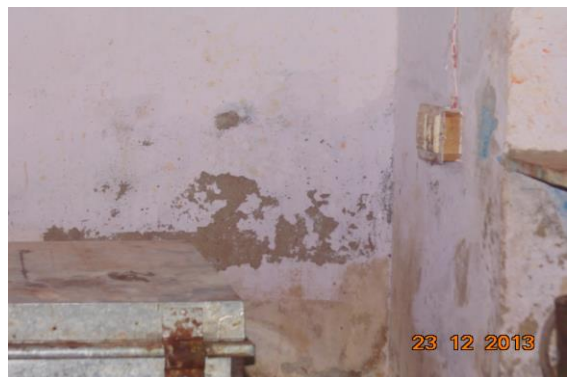
Photo 40

Dampness/Seepage on Wall No. 4 of Part D of Shop No.306 of Ground Floor

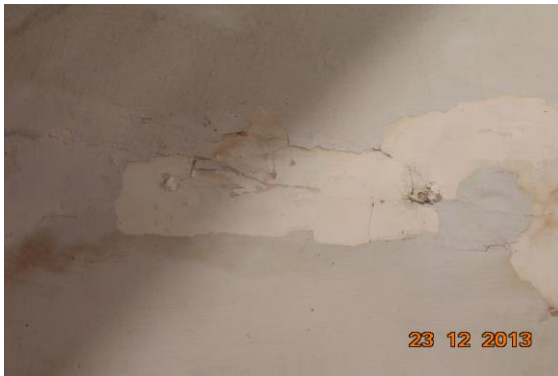
Photo 41

Peeling of Plaster on Roof of Varanda of Shop No.305 of Ground Floor

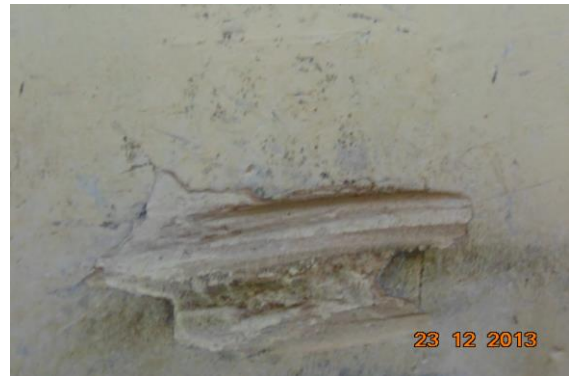
Photo 42

Damaged Portion on Wall No. 1 of Shop No.305 of Ground Floor

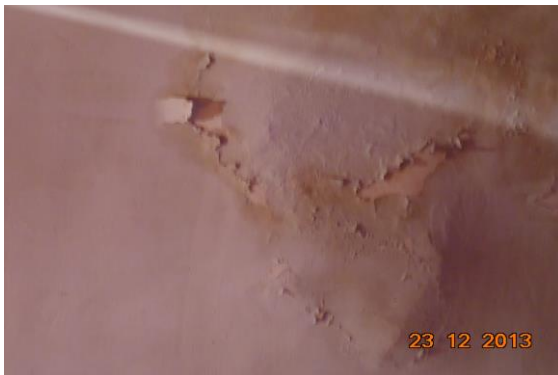
Photo 43

Peeling of Plaster on Roof of Varanda of Shop No.304 of Ground Floor

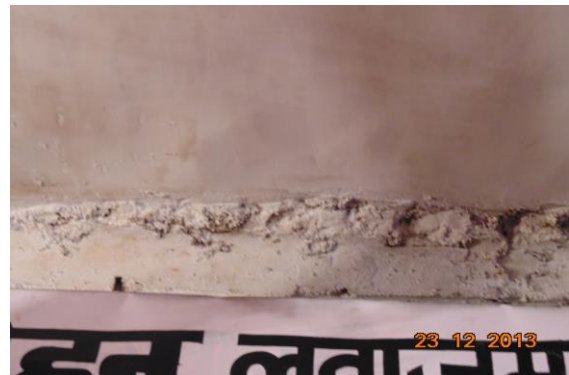
Photo 44

Peeling of Plaster on Roof of Varanda of Shop No.304 of Ground Floor

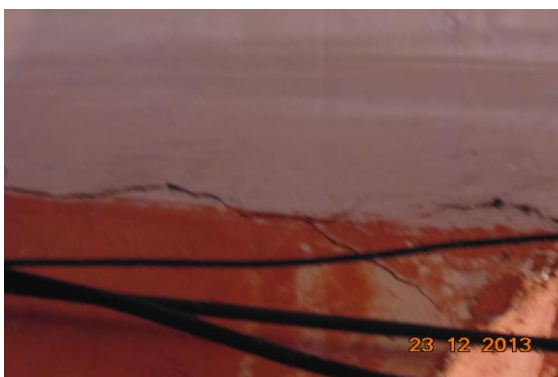
Photo 45

Peeling of Plaster on Beam of Varanda of Shop No.304 of Ground Floor

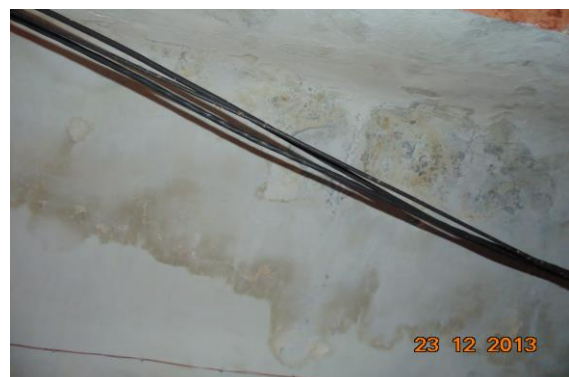
Photo 46

Peeling of Plaster on Roof of Varanda of Shop No.303 of Ground Floor

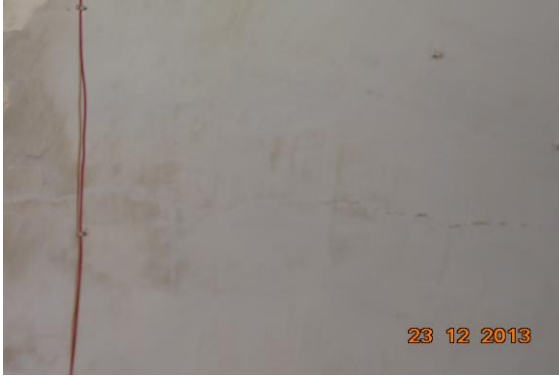
Photo 47

Peeling of Plaster on Roof of Varanda of Shop No.302 of Ground Floor

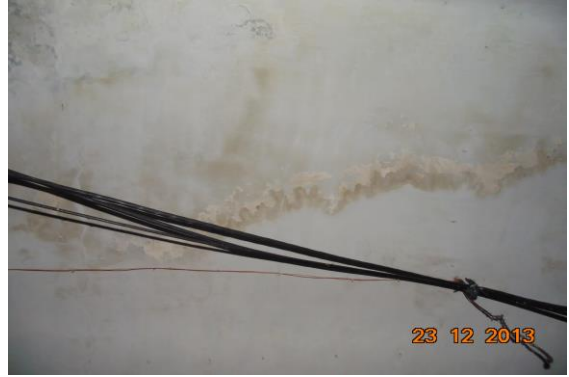
Photo 48

Dampness/Seepage on Roof of Varanda of Shop No.302 of Ground Floor

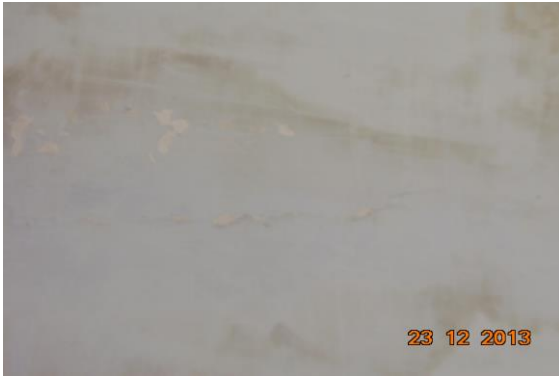
Photo 49

Peeling of Plaster on Roof of Varanda of Shop No.302 of Ground Floor

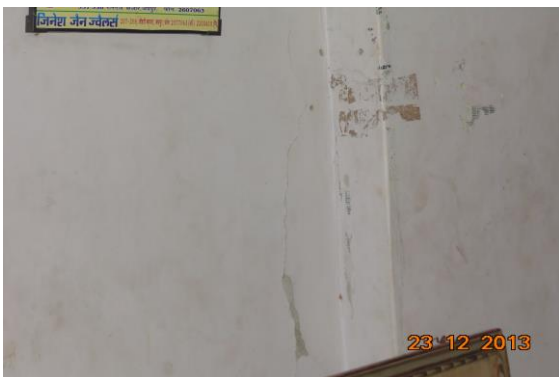
Photo 51

Peeling of Plaster on Wall No. 1 of Shop No.302 of Ground Floor

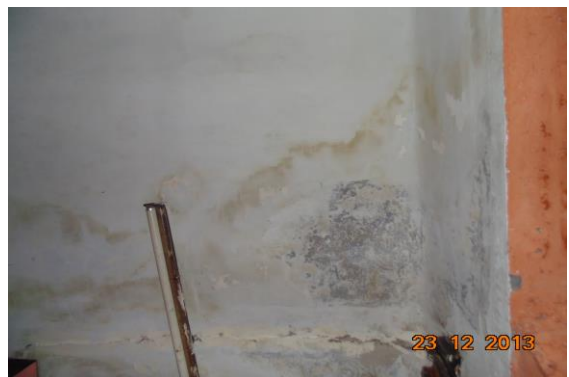
Photo 52

Dampness/Seepage on Roof of Varanda of Shop No.301 of Ground Floor

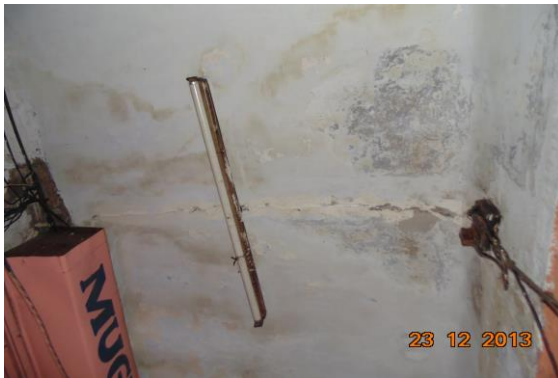
Photo 53

Damaged Portion on Roof of Varanda of Shop No.301 of Ground Floor

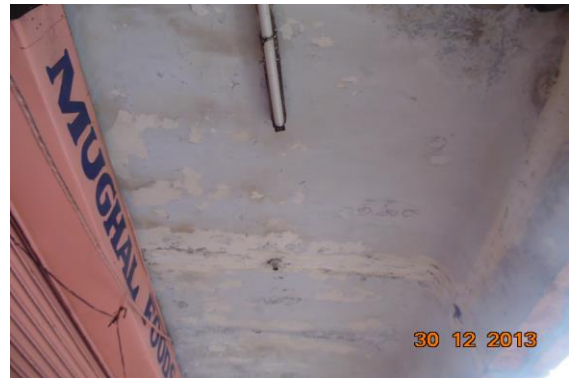
Photo 54

Peeling of Plaster on Roof of Varanda of Shop No. 300, Ground Floor

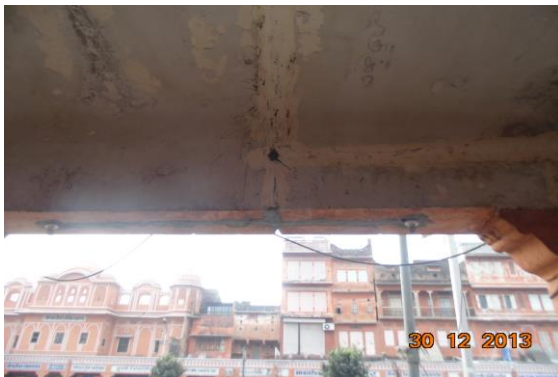
Photo 55

Dampness/Seepage on Beam of Varanda of Shop No. 300, Ground Floor

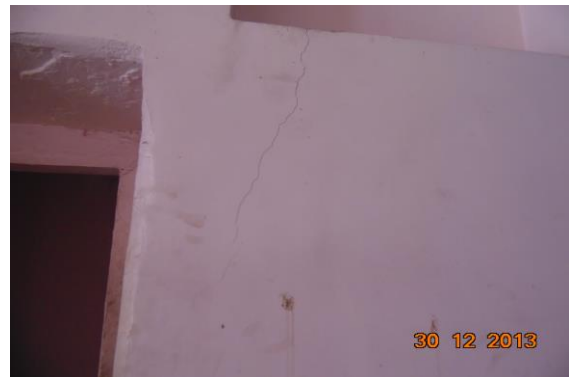
Photo 56

Plaster Crack on Wall No. 1 of Shop No. 300 of Ground Floor

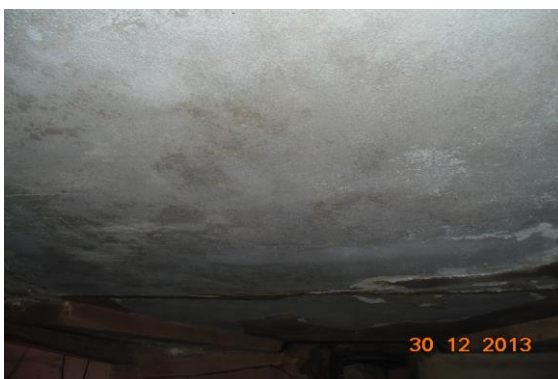
Photo 57

Dampness/Seepage on Roof of Part A of Shop No. 300, Lower Ground Floor

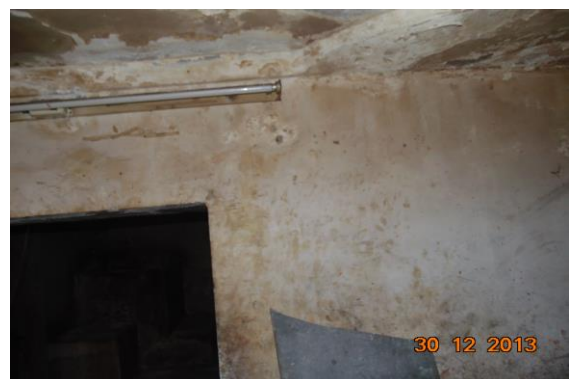
Photo 58

Dampness/Seepage on Wall No. 4 of Part A of Shop No. 300, Lower Ground Floor

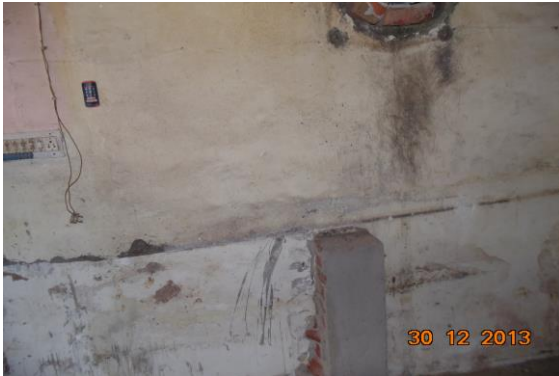
Photo 59

Dampness/Seepage on Wall No. 1 of Part A of Shop No. 300, Lower Ground Floor

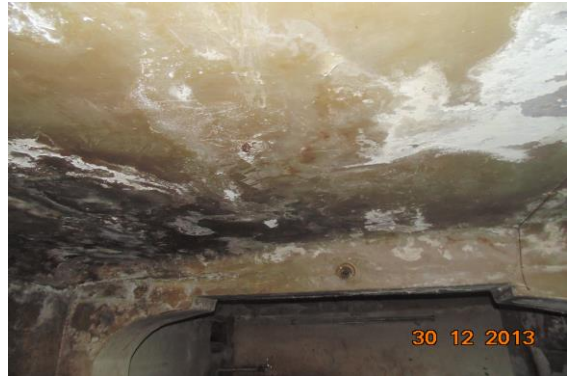
Photo 60

Dampness/Seepage on Roof of Part B of Shop No. 300, Lower Ground Floor

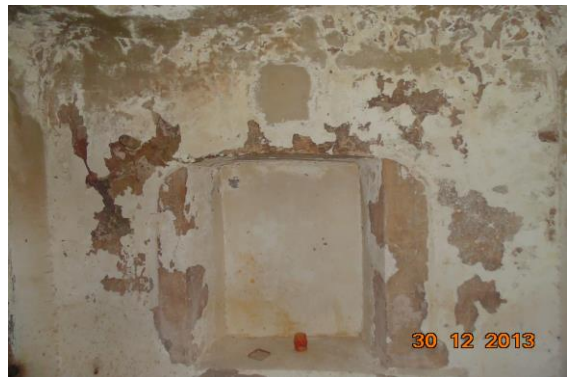
Photo 62

Dampness/Seepage on Wall No. 2 of Part B of Shop No. 300, Lower Ground Floor

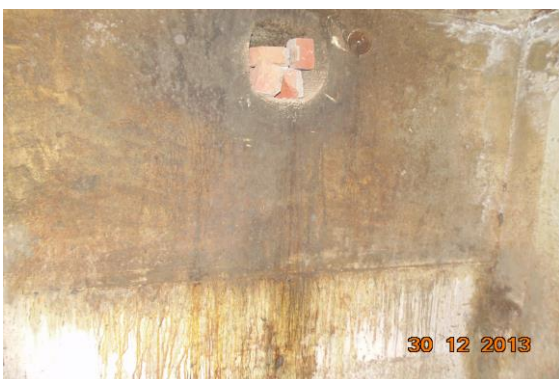
Photo 63

Dampness/Seepage on Wall No. 1 of Part C of Shop No. 300, Lower Ground Floor

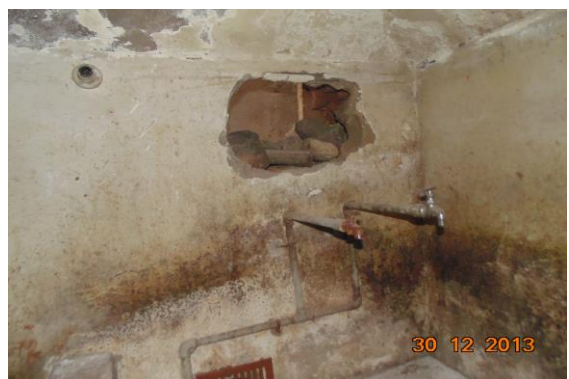
Photo 64

Damaged Portion on Wall No. 1 of Part C of Shop No. 300, Lower Ground Floor

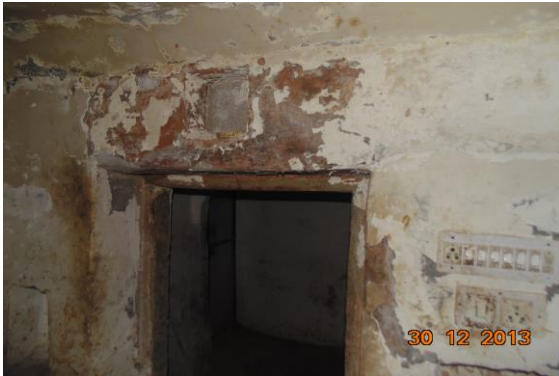
Photo 65

Dampness/Seepage on Wall No. 2 of Room No. 1 of Shop No. 300, Lower Ground Floor

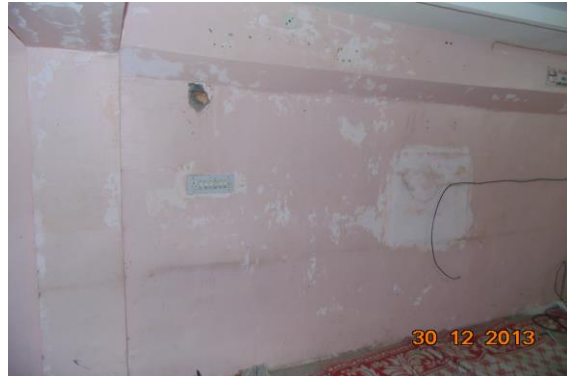
Photo 66

Peeling of Plaster on Wall No. 1 of Hall No. 1 of Shop No. 300, Upper Ground Floor

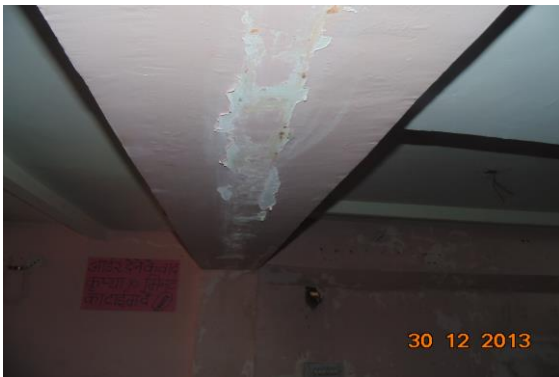
Photo 67

Peeling of Plaster on Roof Beam of Hall No. 1 of Shop No. 301, Upper Ground Floor

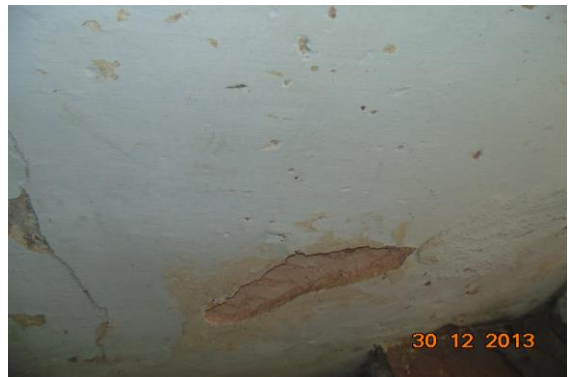
Photo 68

Peeling of Plaster on Wall No. 1 of Staircase Ground Floor to First Floor of Above Shop No.300, First Floor

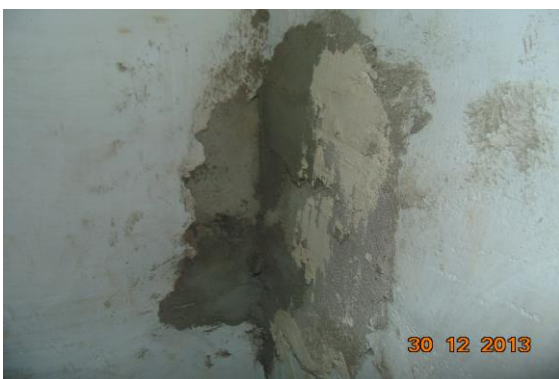
Photo 69

Peeling of Plaster on Wall No. 1 & 4 of Staircase Ground Floor to First Floor of Above Shop No.300, First Floor

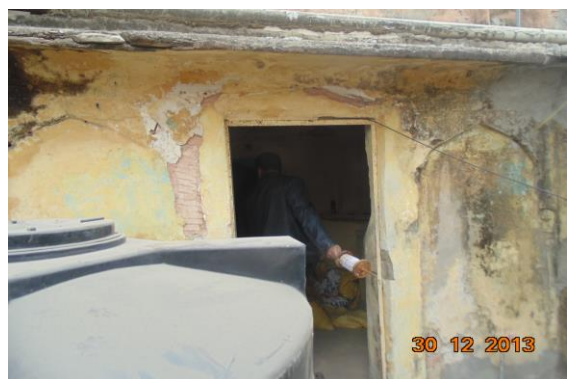
Photo 70

Peeling of Plaster on Wall No. 1 of Open Sky of Above Shop No.300, First Floor

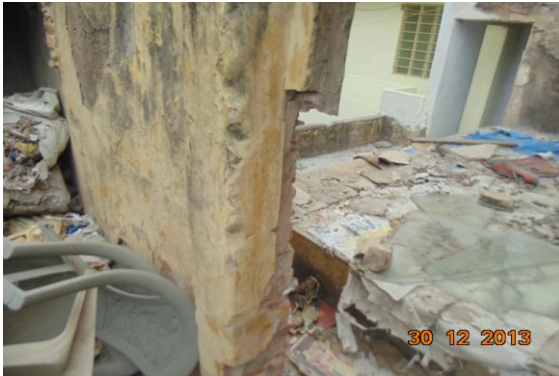
Photo 71

Damaged Portion on Wall No. 3 & Right Side of Entry Gate of Above Shop No.300, First Floor

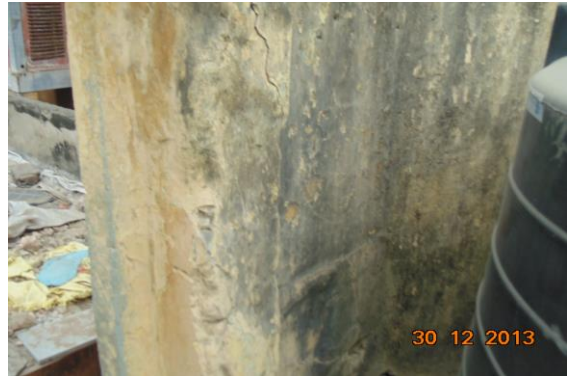
Photo 72

Damaged Portion on Wall No. 3 & Left Side of Entry Gate of Above Shop No.300, First Floor
