### Pre Building Condition Survey Report

Name and Address of Structure :	Badi Chopar to Ramp Area (UP Line)
---------------------------------	------------------------------------

Name of the Project	<b>Contract JMRC-UG1B</b> “Design and Construction of Tunnel between Chandpole and Badi Chouper and reverse line by Shield TBM, Underground Metro Stations at Choti Chouper and Badi Chouper by Cut and Cover Methods on East West Corridor of Jaipur Metro Rail Corporation Limited .”	
Owner :

Pre Building Condition Survey Report Badi Chopar to Ramp Area (UP Line)

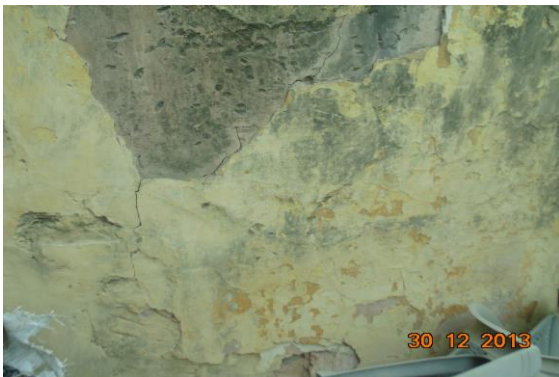
Photo 73

Damaged Portion on Wall No. 3 of Entry Gate of Above Shop No.300, First Floor

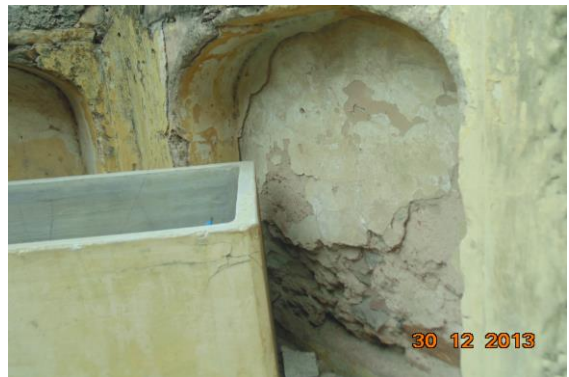
Photo 74

Damaged Portion on Wall No. 2 of Entry Gate of Above Shop No.300, First Floor

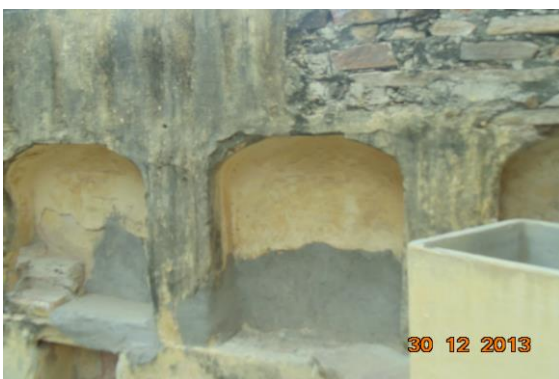
Photo 75

Peeling of Plaster on Wall No. 4 of Entry Gate of Above Shop No.300, First Floor

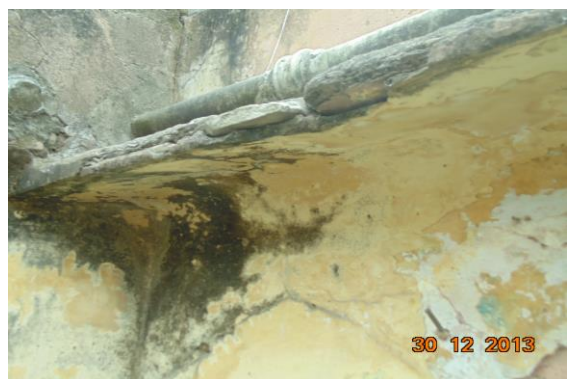
Photo 76

Damaged Portion on Wall No. 1 & Sunshade of Entry Gate of Above Shop No.300, First Floor

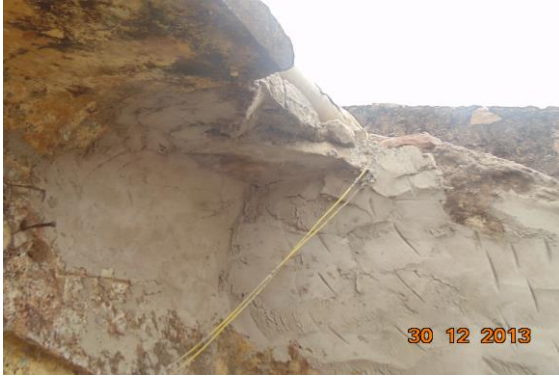
Photo 77

Peeling of Plaster on Wall No. 1 & Sunshade of Entry Gate of Above Shop No.300, First Floor

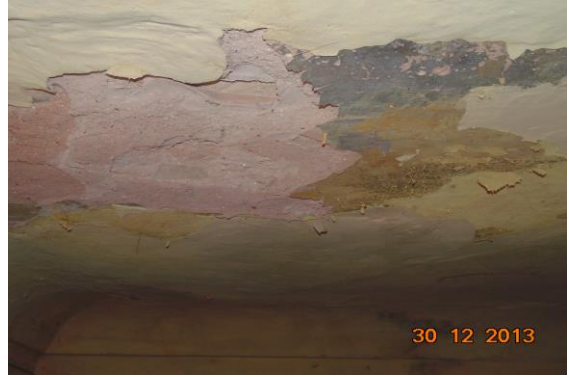
Photo 78

Peeling of Plaster on Roof of Room No. 1 of Above Shop No.300, First Floor

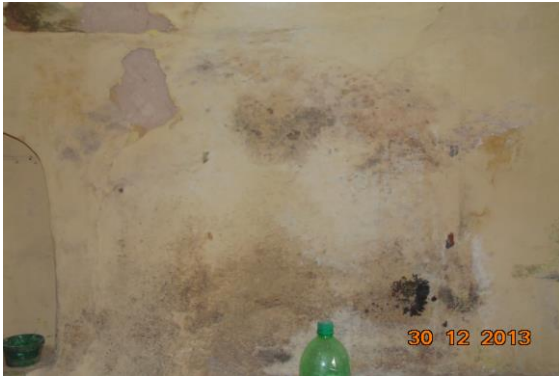
Photo 79

Dampness/Seepage on Wall No. 2 of Room No. 1 of Above Shop No.300, First Floor

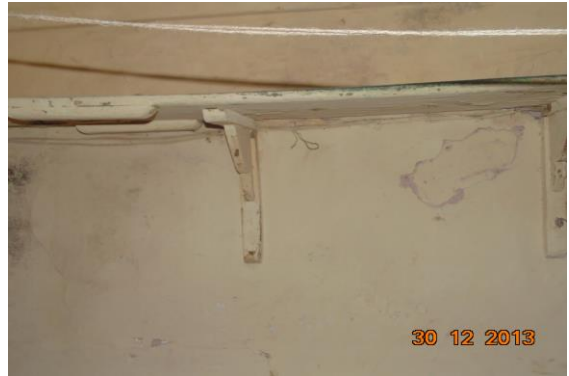
Photo 80

Dampness/Seepage on Wall No. 1 of Room No. 1 of Above Shop No.300, First Floor

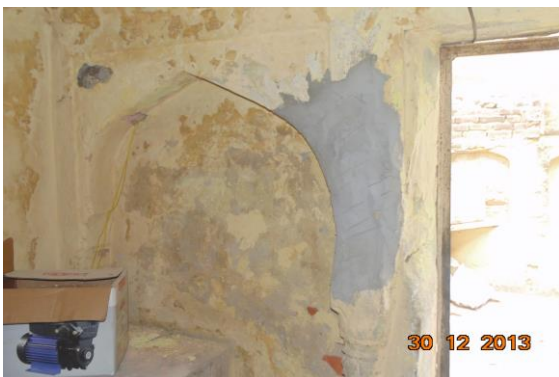
Photo 81

Dampness/Seepage on Wall No. 3 of Room No. 1 of Above Shop No.300, First Floor

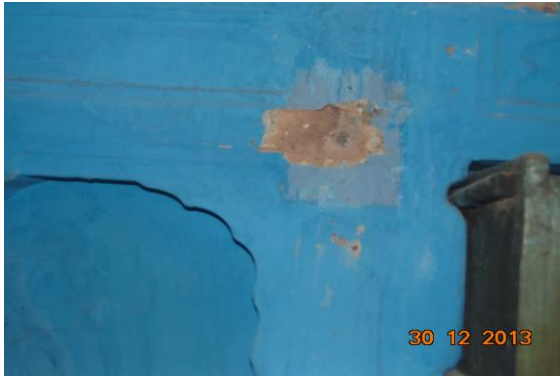
Photo 83

Damaged Portion on Wall No. 3 of Room No. 2 of Above Shop No.300, First Floor

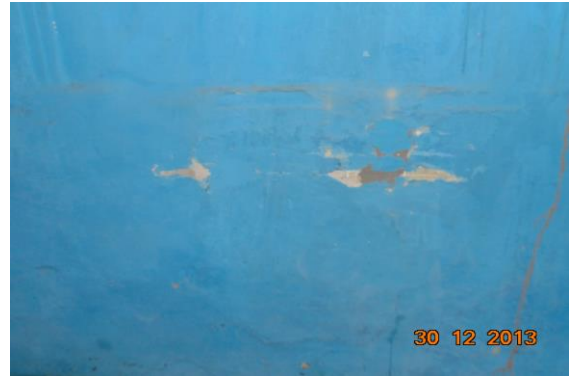
Photo 84

Peeling of Plaster on Wall No. 1 of Room No. 2 of Above Shop No.300, First Floor

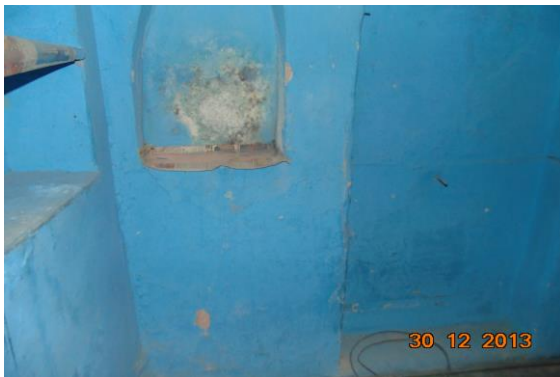
Photo 85

Damaged Portion on Wall No. 2 of Room No. 2 of Above Shop No.300, First Floor

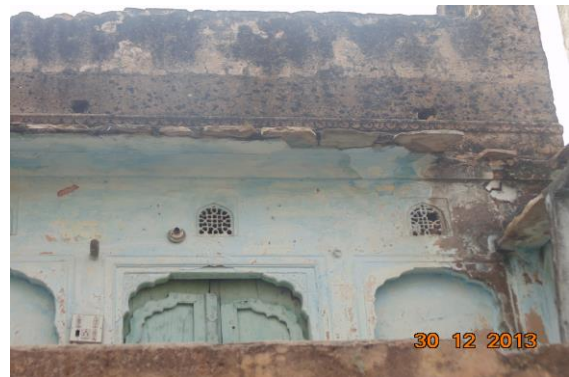
Photo 86

Damaged Portion on Shade of Open Sky of Above Shop No.300, Second Floor

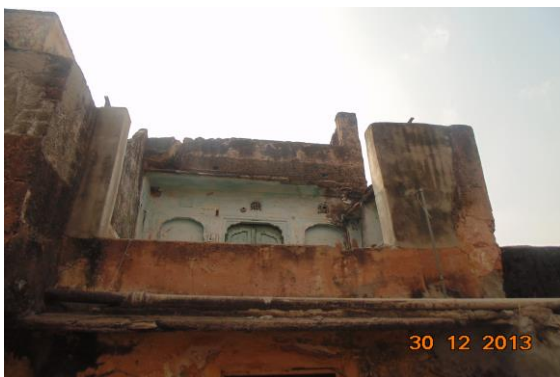
Photo 87

Peeling of Plaster on Wall No. 3 of Open Sky of Above Shop No.300, Second Floor

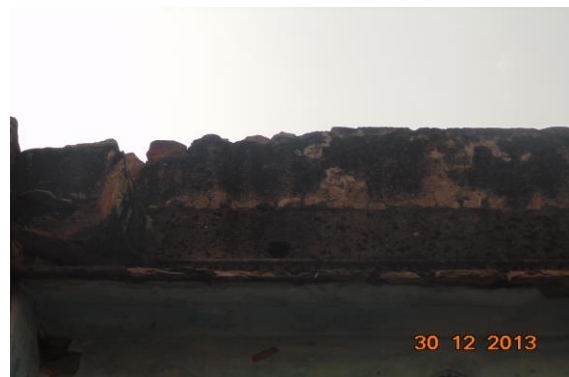
Photo 88

Damaged Portion on Parapit Wall of Open Sky of Above Shop No.300, Second Floor

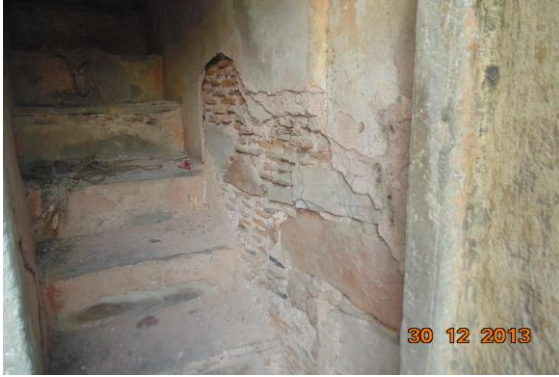
Photo 89

Damaged Portion on Wall No. 2 of Stair First Floor to Second Floor of Above Shop No.300, Second Floor

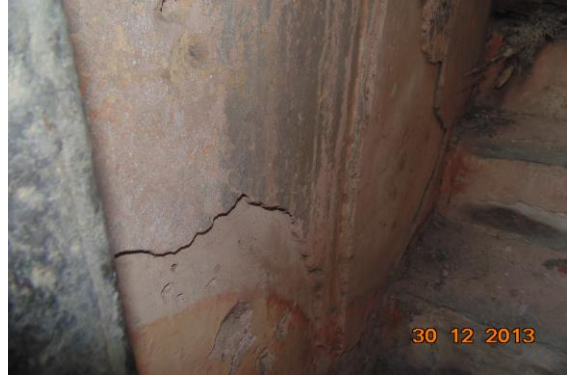
Photo 90

Damaged Portion on Wall No. 1 of Stair First Floor to Second Floor of Above Shop No.300, Second Floor

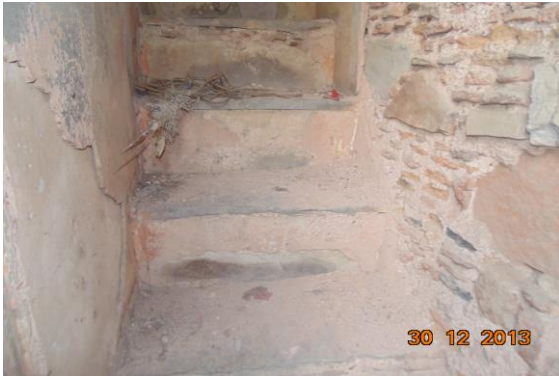
Photo 91

Damaged Portion on Stair Step First Floor to Second Floor of Above Shop No.300, Second Floor

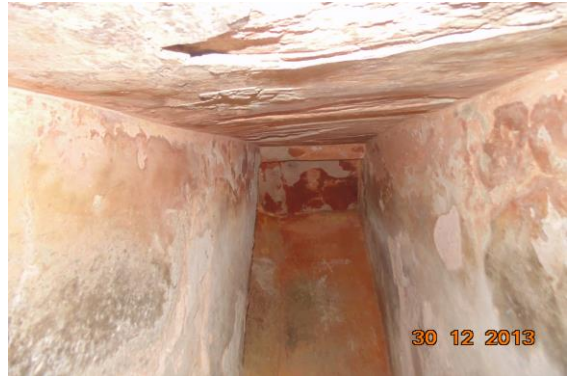
Photo 92

Damaged Portion on Roof of Stair First Floor to Second Floor of Above Shop No.300, Second Floor

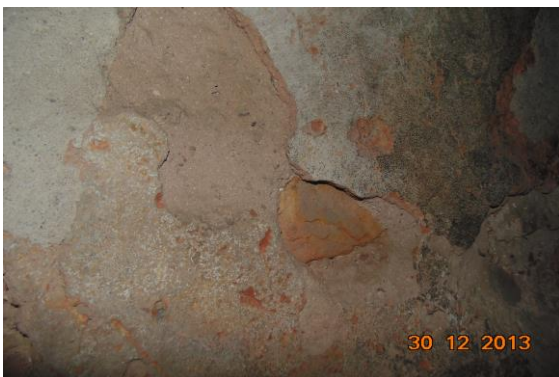
Photo 93

Peeling of Plaster on Wall No. 2 of Back Side of Stair First Floor to Second Floor of Above Shop No.300, First Floor

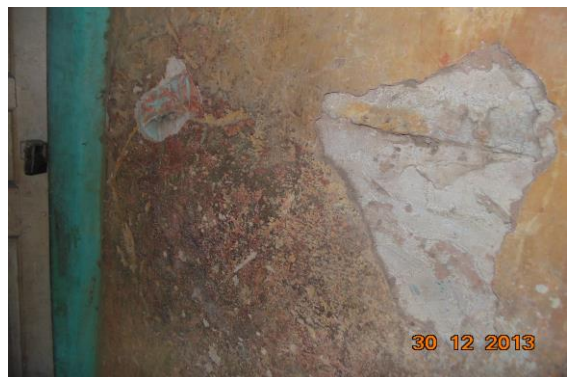
Photo 94

Damaged Portion on Wall No. 1 of Back Side of Stair First Floor to Second Floor of Above Shop No.300, First Floor

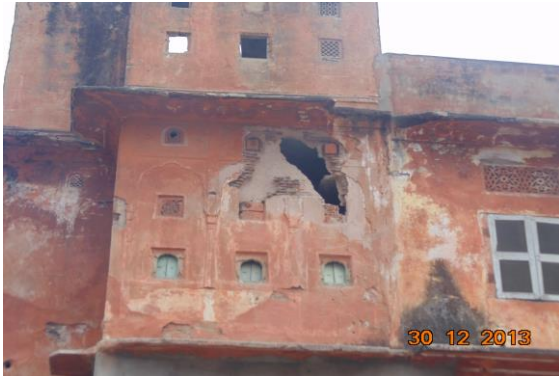
Photo 95

Damaged Portion on Outer Wall of External Façade of Above Shop No.300, Second Floor

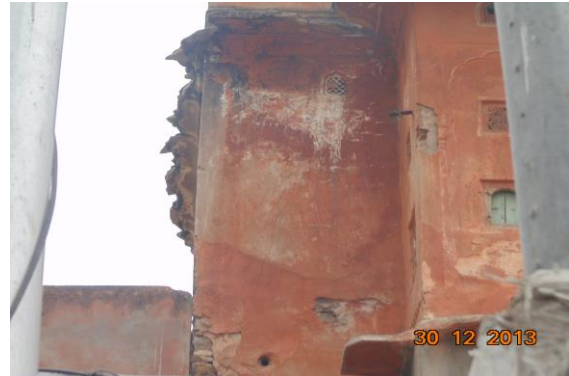
Photo 96

Damaged Portion on Left Side Shed of External Façade of Above Shop No.300, Second Floor

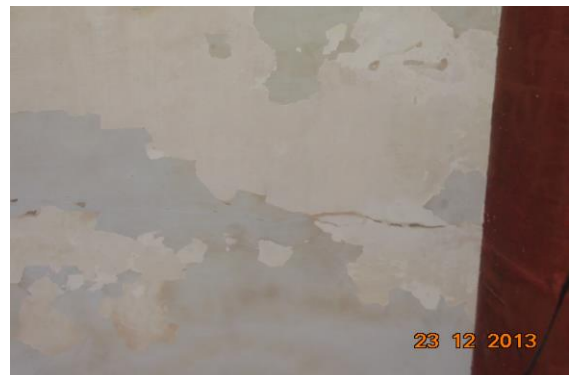
The average width of cracks is 0.9mm and average length of cracks is 2.4m. The maximum crack width is 1mm and minimum width is 0.8mm.

Photo 4  
Horizontal Crack on Roof of Varanda of Shop No.299, Ground Floor  
Approx. Width = 0.8mm, Approx. Length = 2m.  
Distance from Leftside External Column = 0.6m, Height from Floor = 3m

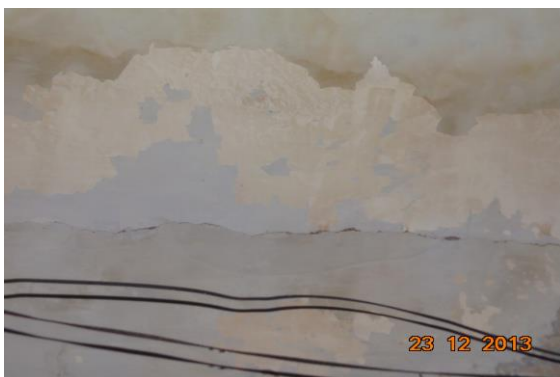
Photo 5  
Horizontal Crack on Roof of Varanda of Shop No.299, Ground Floor  
Approx. Width = 1mm, Approx. Length = 2.8m.  
Distance from Leftside External Column = 0m, Height from Floor = 2.5m.

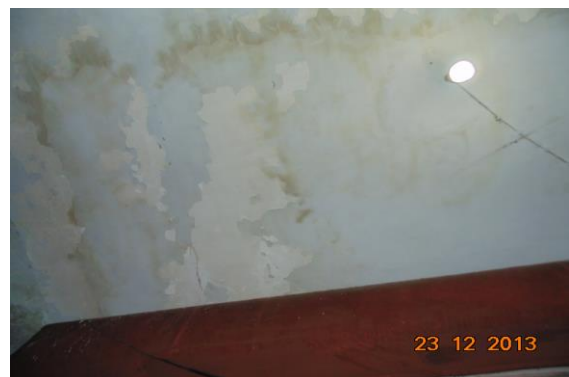
Photo 6  
Peeling of Plaster on Roof of Varanda of Shop No.299 of Ground Floor

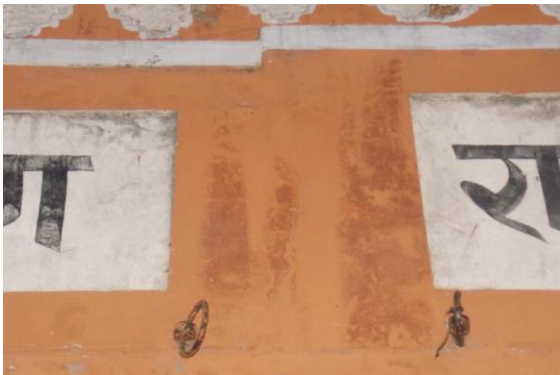
Photo 3  
Inclined Crack on of External Col, Shop No. 296, Ground Floor  
Approx. Width = 1mm, Approx. Length = 0.8m.  
Height from Floor = 3m.

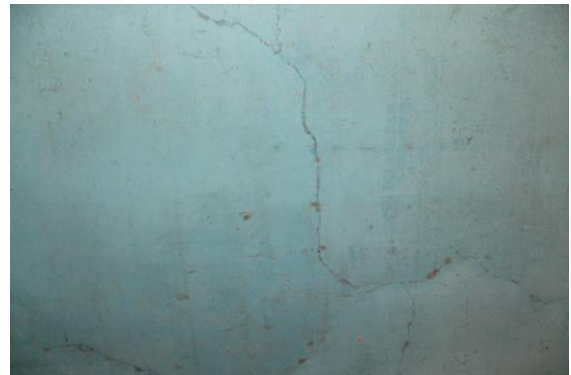
Photo 4  
Inclined Crack on Wall No. 4 of Part B of Shop No.297, Ground Floor  
Approx. Width = 0.5mm, Approx. Length = 1.8m.  
Distance from Wall No.2 = 1.1m, Height from Floor = 0m.

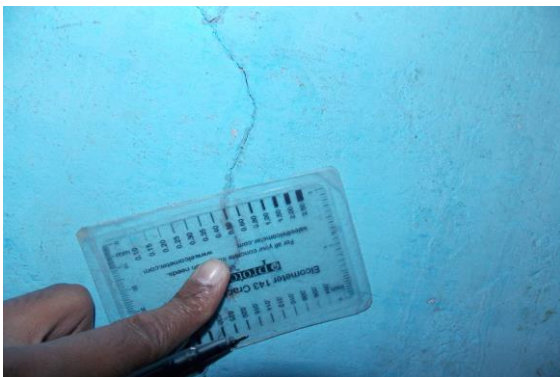
Photo 4A  
Inclined Crack on Wall No. 4 of Part B of Shop No.297, Ground Floor  
Approx. Width = 0.5mm, Approx. Length = 1.8m.  
Distance from Wall No.2 = 1.1m, Height from Floor = 0m.

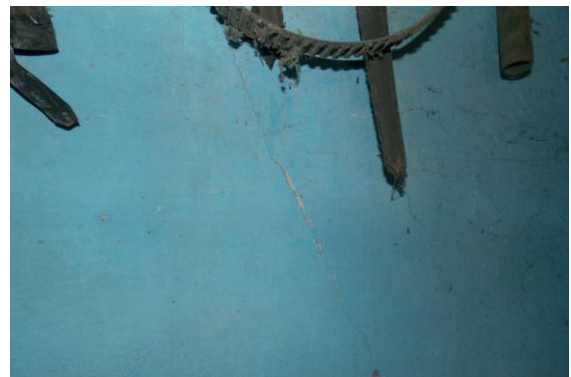
Photo 5  
Inclined Crack on Wall No. 4 of Part B of Shop No.297, Ground Floor  
Approx. Width = 0.6mm, Approx. Length = 1.2m.  
Distance from Wall No.2 = 0.25m, Height from Floor = 1.2m.

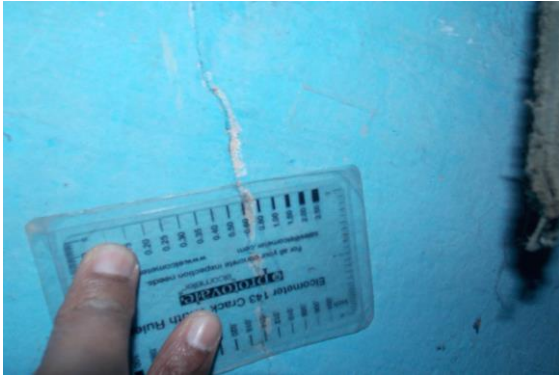
Photo 5A

Inclined Crack on Wall No. 4 of Part B of Shop No.297, Ground Floor  
Approx. Width = 0.6mm, Approx. Length = 1.2m.  
Distance from Wall No.2 = 0.25m, Height from Floor = 1.2m.

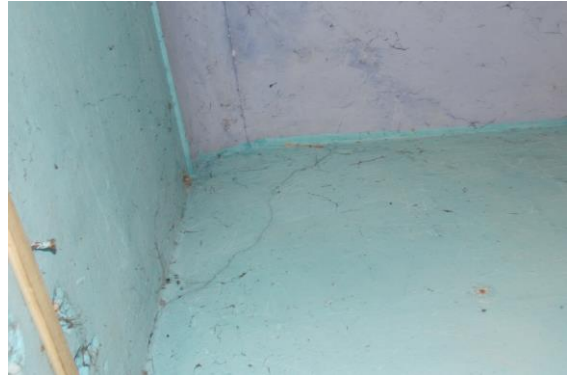
Photo 6

Inclined Crack on Wall No. 1 of Part A of Shop No.297, Ground Floor  
Approx. Width = 0.35mm, Approx. Length = 1m.  
Distance from Wall No.3 = 0.25m, Height from Floor = 2.3m.

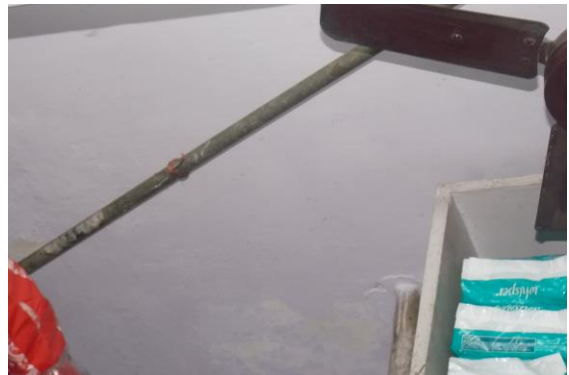
Photo 8

Peeling of Plaster on Roof of Shop No. 296 of Ground Floor

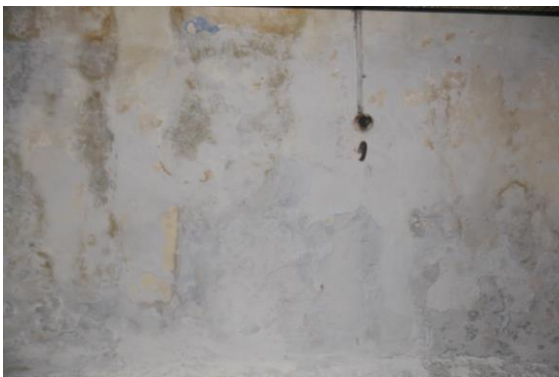
Photo 9

Peeling of Plaster on Varandah, Roof of Shop No. 296, Ground Floor

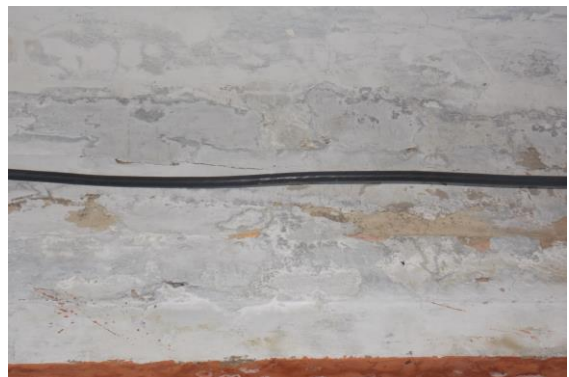
Photo 10

Peeling of Plaster on External Beam of Shop No. 296, Ground Floor

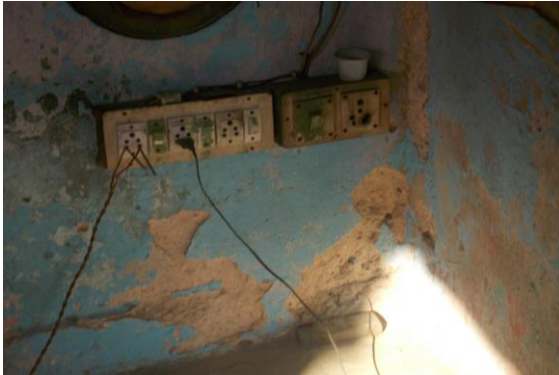
Photo 11  
Peeling of Plaster on Wall No. 2 & 4 of Part A of Shop No.297 of Ground Floor

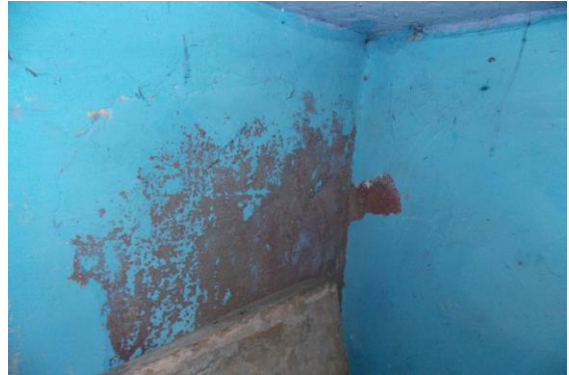
Photo 12  
Peeling of Plaster on Wall No. 1 & 3 of Part B of Shop No.297 of Ground Floor

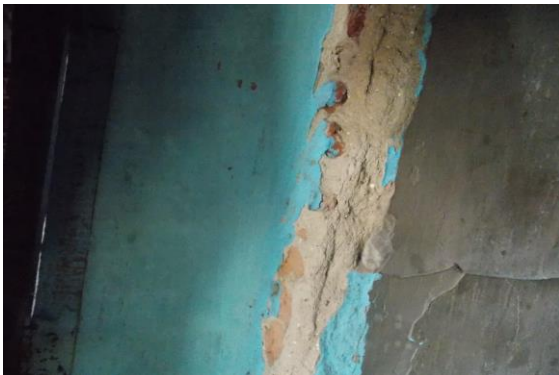
Photo 13  
Peeling of Plaster on Wall No. 4 of Part A of Shop No.297 of Ground Floor

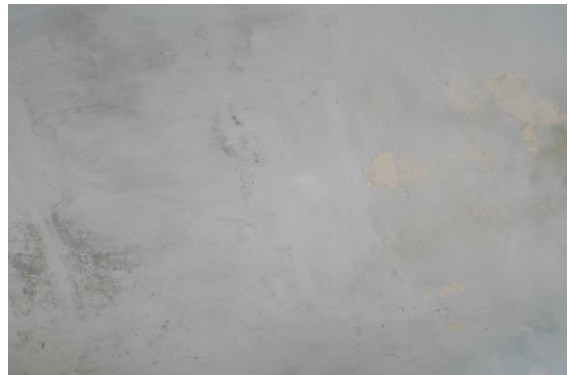
Photo 14  
Peeling of Plaster on Roof of Varanda of Shop No.297 of Ground Floor

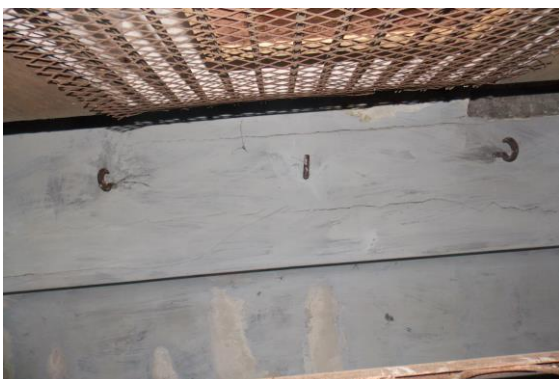
Photo 5  
Horizontal Crack on Beam of Shop No. 294, Ground Floor  
Approx. Width = 2.5mm, Approx. Length = 2.7m.  
Distance from Wall No. 1 & 2 = 0m, Height from Floor = 3m.

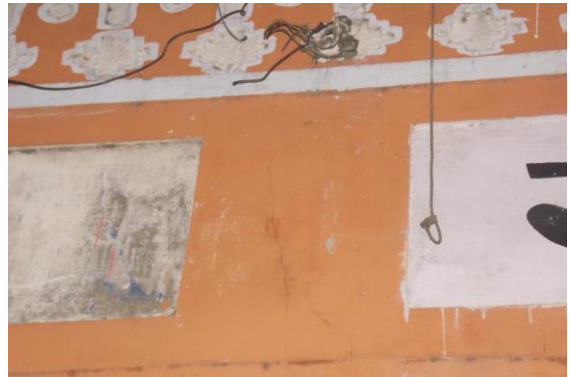
PHOTO 7

Inclined Crack on Left Side of External Column, Shop No. 294, Ground Floor

Approx. Width = 1.5mm, Approx. Length = 1.3m.  
Height from Floor = 3m

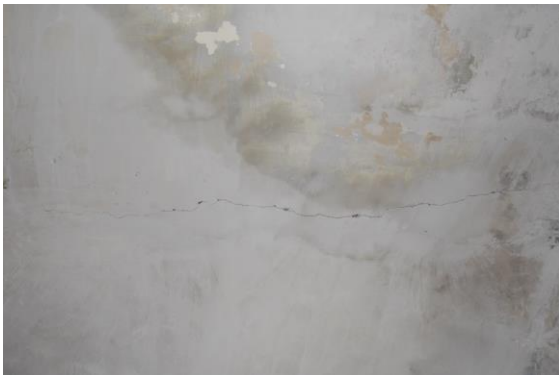
Photo 8

Horizontal Crack on Roof of Varandah, Shop No. 295, Ground Floor

Approx. Width = 1mm, Approx. Length = 2m.  
Distance from = m, Height from Floor = 3.5m.

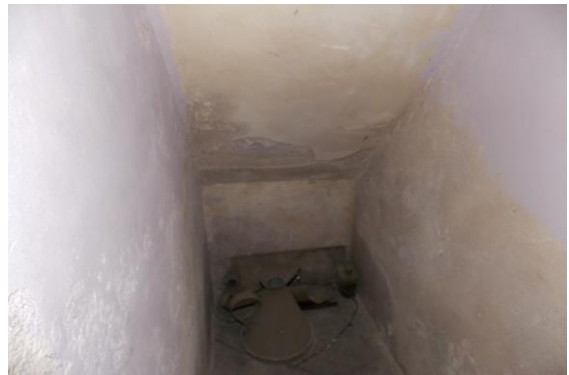
Photo 9

Dampness/Seepage on Wall No. 1, 2, 4 & Roof of Store of Shop No. 294, Ground Floor

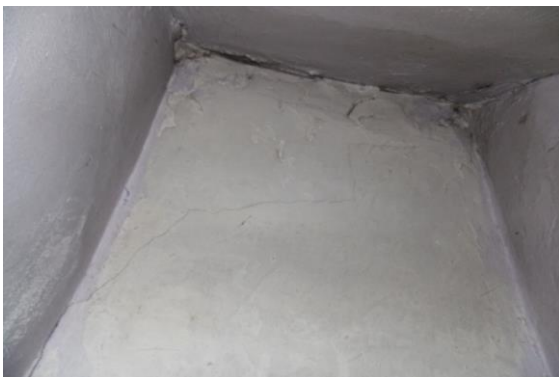
Photo 10

Peeling of Plaster on Roof of Store of Shop No. 294, Ground Floor

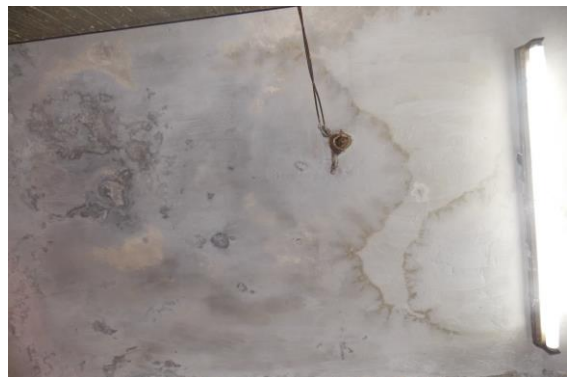
Photo 11

Dampness/Seepage on Roof of Varandah of Shop No. 294, Ground Floor

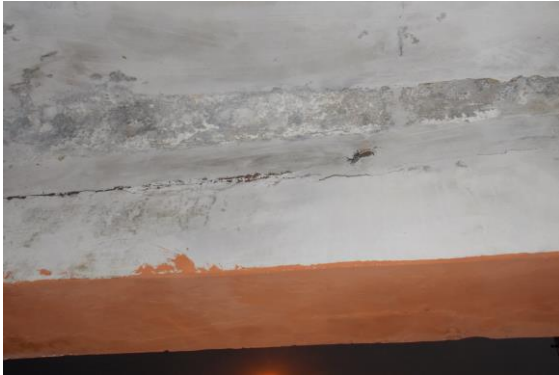
Photo 12  
Exposed Reinforcement on Beam of Shop No. 294 of Ground Floor

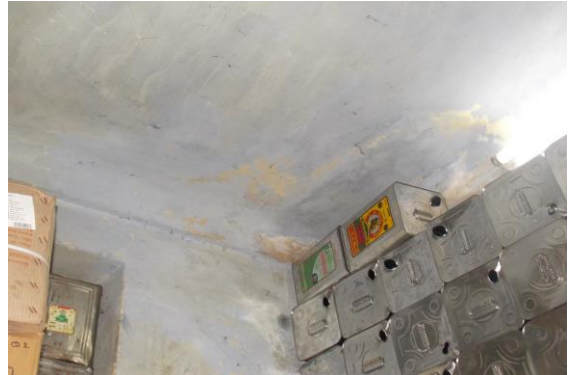
Photo 13  
Peeling of Plaster on Wall No. 2, 4 & Roof of Shop No. 295 of Ground Floor

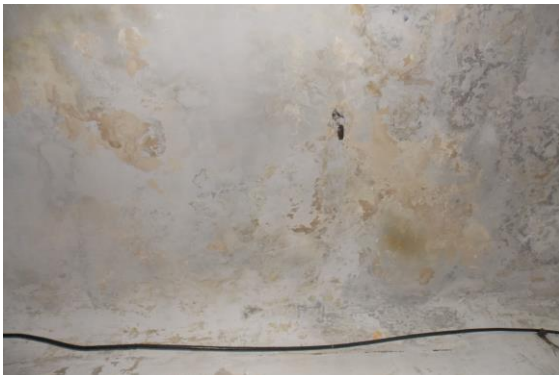
Photo 14  
Peeling of Plaster on Roof of Varandah of Shop No. 295, Ground Floor

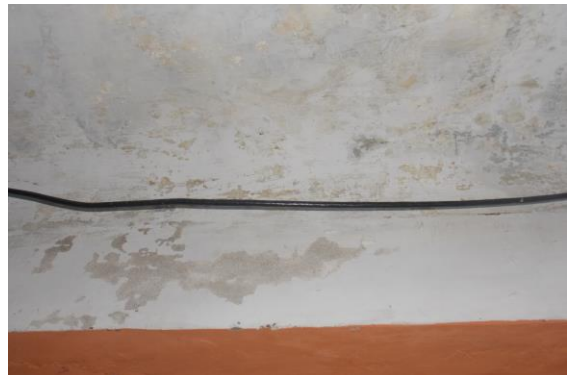
Photo 15  
Peeling of Plaster on External Beam of Shop No. 295 of Ground Floor

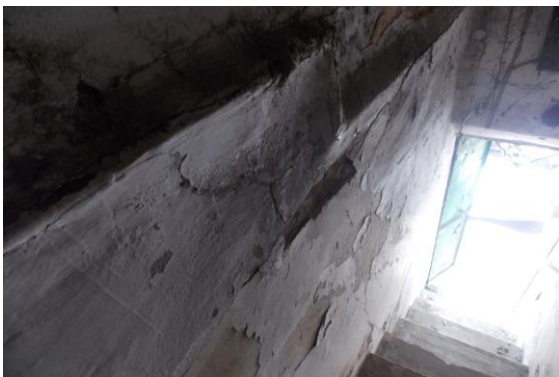
Photo 16  
Peeling of Plaster on Wall No. 2 of Stair GF to FF

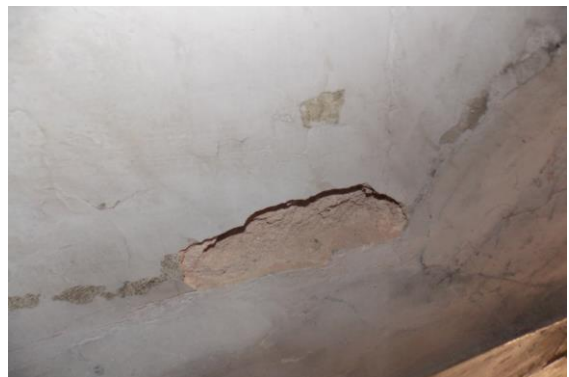
Photo 17  
Peeling of Plaster on Wall No. 2 of Stair GF to FF

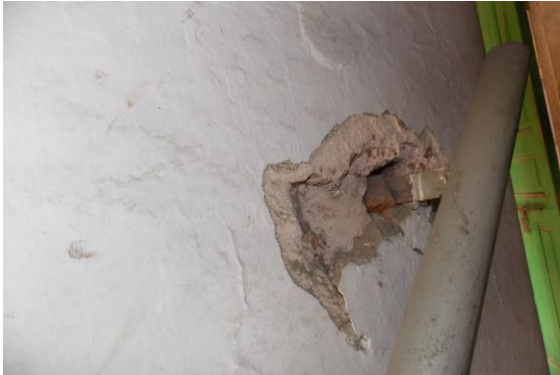
Photo 18  
Peeling of Plaster on Wall No. 1 of First Floor

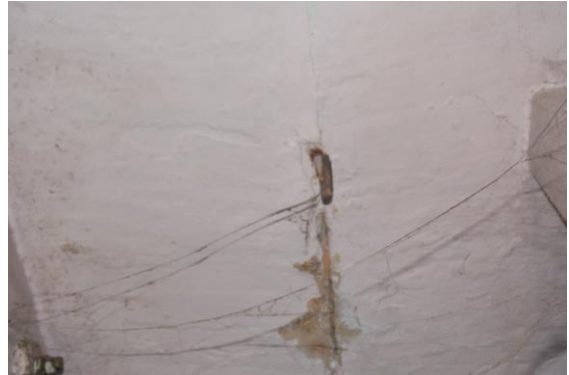
Photo 19  
Peeling of Plaster on Roof of Lobby of First Floor

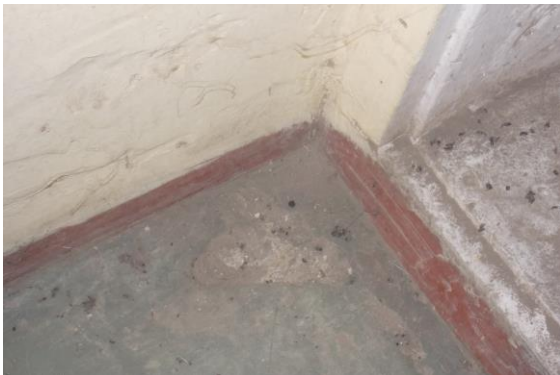
Photo 20  
Peeling of Plaster on Floor of Room No. 1 of First Floor

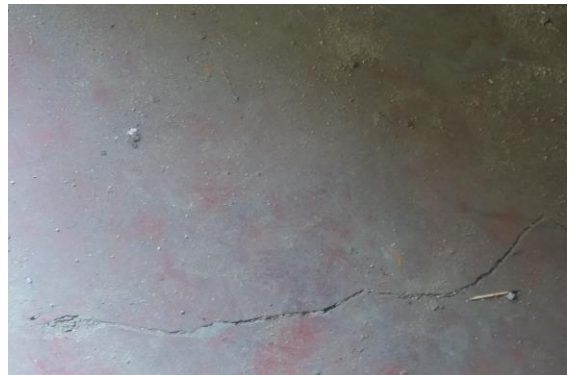
Photo 21  
Peeling of Plaster on Floor of Room No. 1 of First Floor

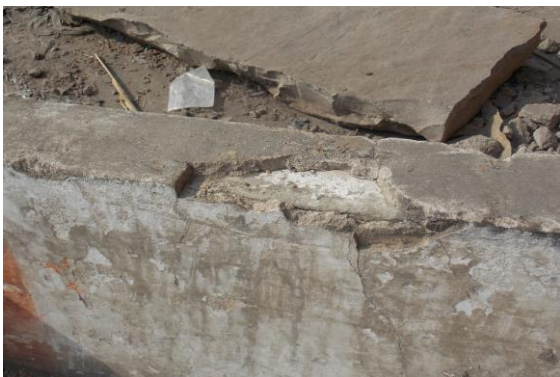
Photo 22  
Peeling of Plaster on Wall No. 2 of Varnadah of First Floor

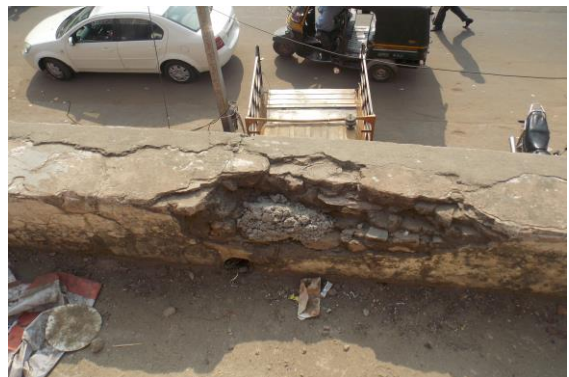
Photo 23  
Damaged Portion on Wall No. 4 of First Floor

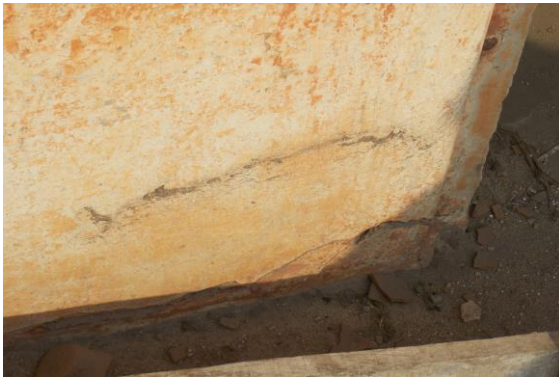
Photo 24  
Peeling of Plaster on Wall No. 3 of First Floor

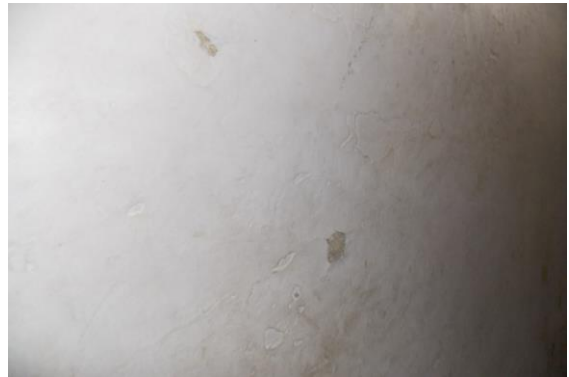
Photo 25  
Peeling of Plaster on Wall No. 1 of Stair FF to SF

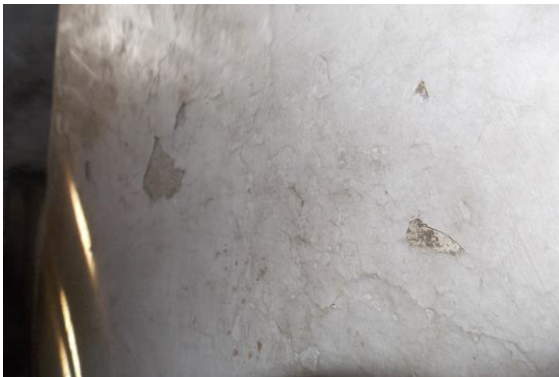
Photo 26  
Peeling of Plaster on Wall No. 2 of First Floor

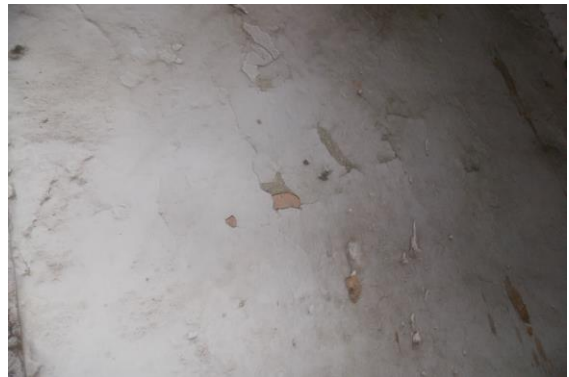
Photo 27  
Peeling of Plaster on Wall No. 4 of First Floor

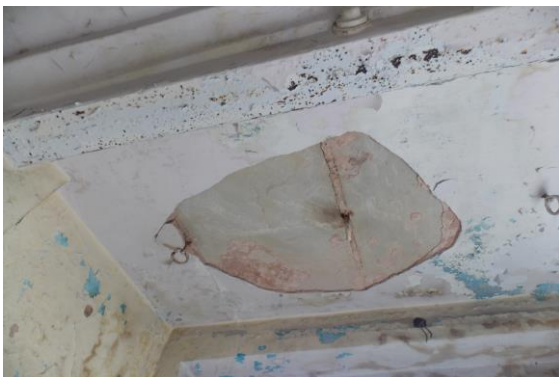
Photo 28  
Peeling of Plaster on Roof of Room No. 2 of Second Floor

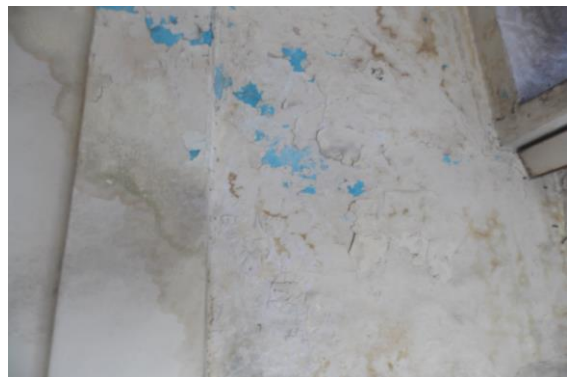
Photo 29  
Dampness/Seepage on Wall No. 4 of Second Floor

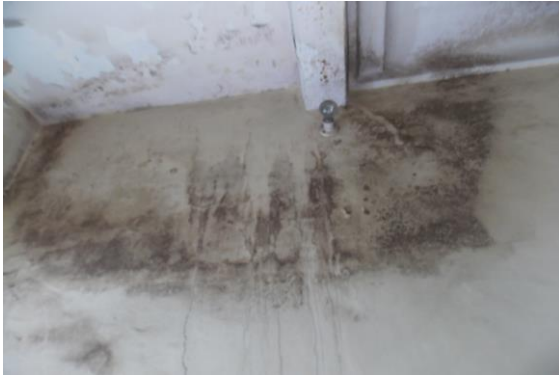
Photo 30  
Dampness/Seepage on Wall No. 3 of Second Floor

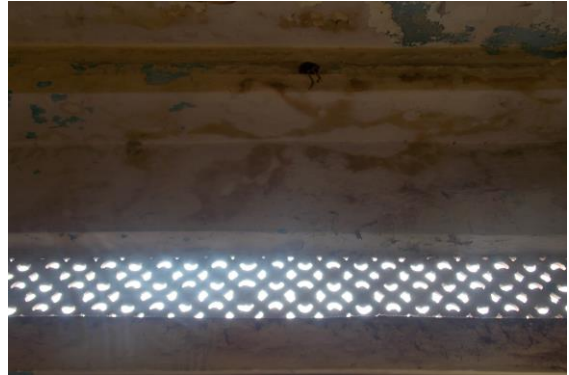
Photo 31  
Dampness/Seepage on Wall No. 2 of Second Floor

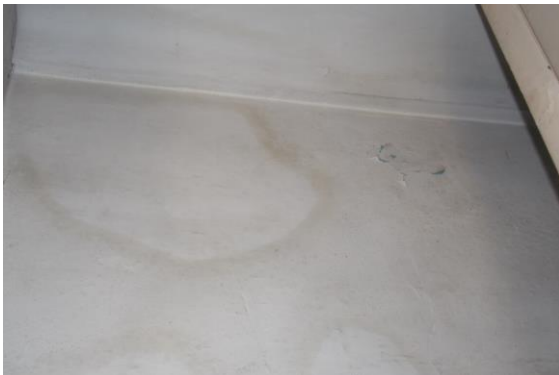
Photo 32  
Dampness/Seepage on Wall No. 1 of Second Floor

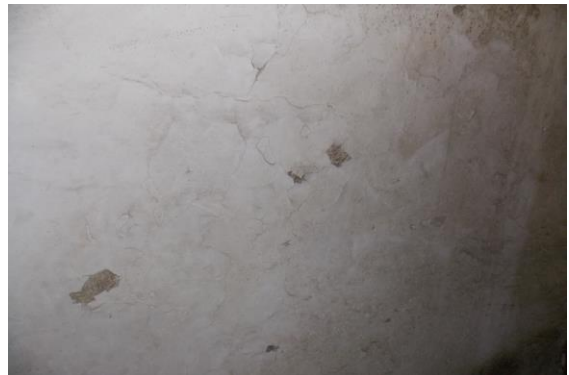
Photo 33  
Peeling of Plaster on Wall No. 1 of Stair SF to TF

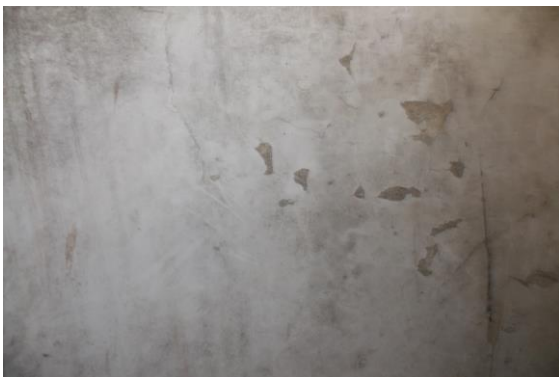
Photo 34  
Peeling of Plaster on Wall No. 4 of Second Floor

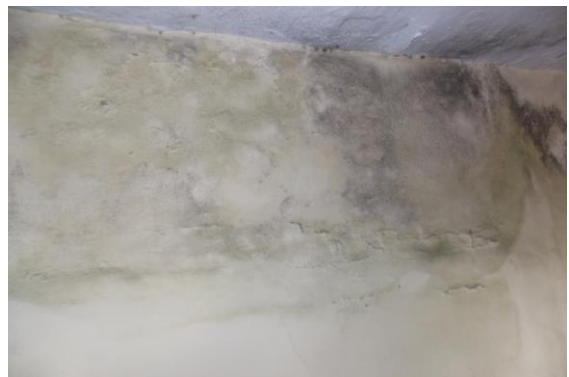
Photo 35  
Dampness/Seepage on Wall No. 4 of Room No. 1 of Third Floor

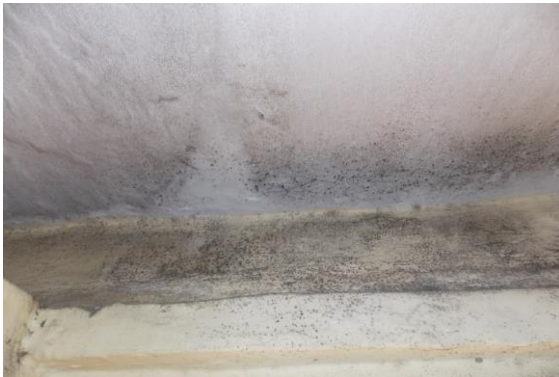
Photo 36  
Dampness/Seepage on Wall No. 3 of Third Floor

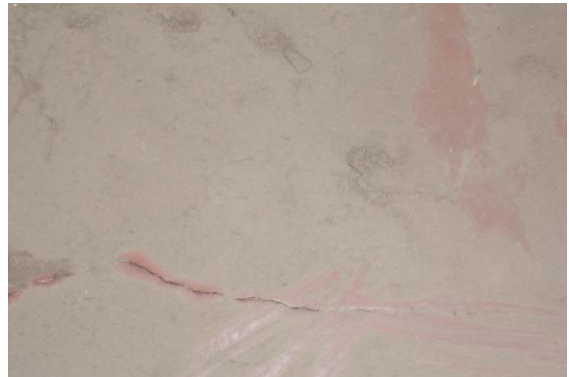
Photo 37  
Plaster Crack on Floor of Third Floor

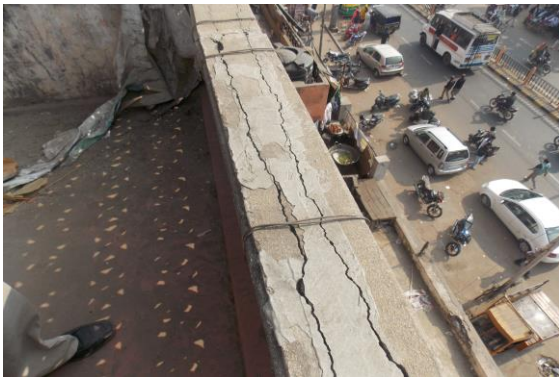
Photo 38  
Damaged Portion on Parapet Wall of Terrace

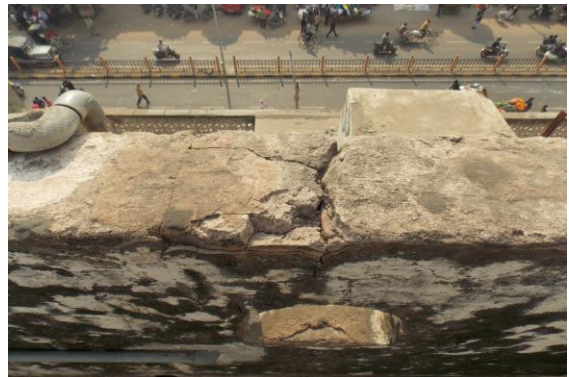
Photo 39  
Peeling of Plaster on Parapet Wall 3 of Terrace

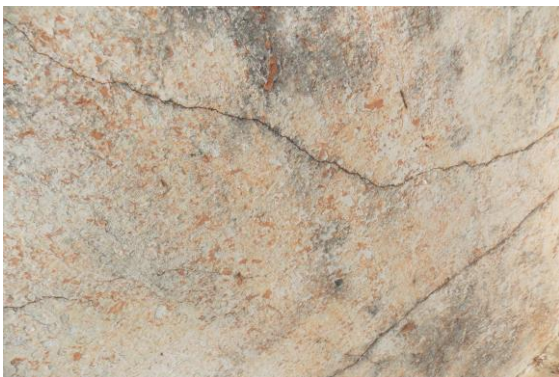
Photo 40  
Plaster Crack on Parapet Wall 1 of Terrace

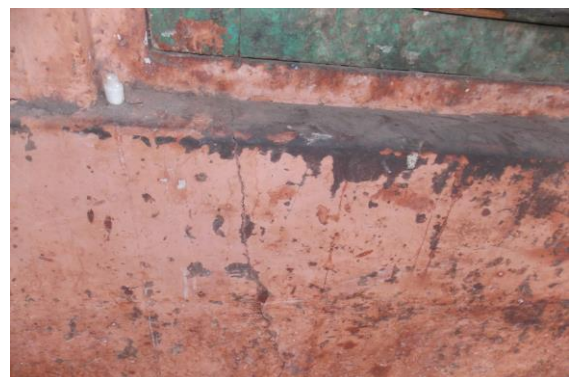
Photo 6

Inclined Crack on Wall No. 4 of Varandah 2, House No. 2424 First Floor  
Approx. Width = 1mm, Approx. Length = 1m.  
Distance from w1 = 3m, Height from Floor = 0.2m.

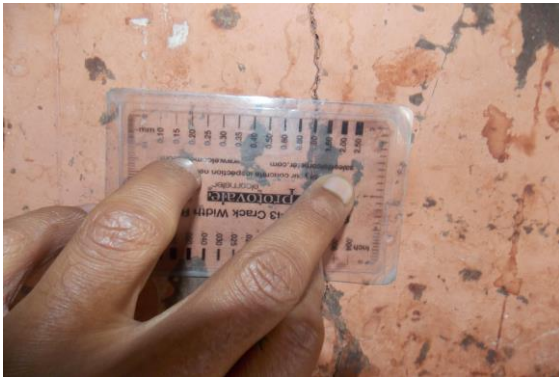
Photo 6A

Inclined Crack on Wall No. 4 of Varandah 2, House No. 2424 First Floor  
Approx. Width = 1mm, Approx. Length = 1m.  
Distance from w1 = 3m, Height from Floor = 0.2m.

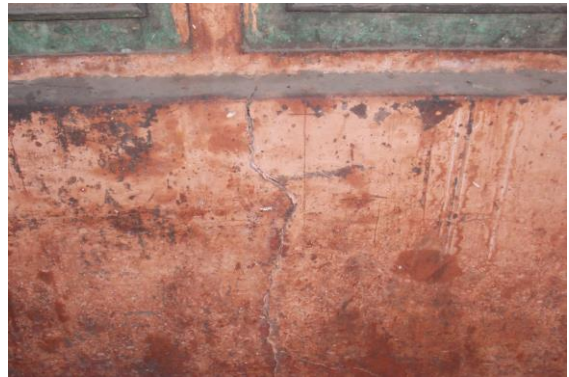
Photo 7

Inclined Crack on Wall No. 4 of Varandah 2, House No. 2424 First Floor  
Approx. Width = 5mm, Approx. Length = 0.8m.  
Distance from w1 = 3.5m, Height from Floor = 0.25m.

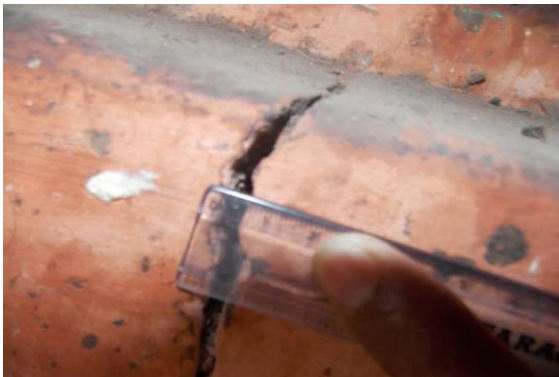
Photo 7A

Inclined Crack on Wall No. 4 of Varandah 2, House No. 2424 First Floor  
Approx. Width = 5mm, Approx. Length = 0.8m.  
Distance from w1 = 3.5m, Height from Floor = 0.25m.

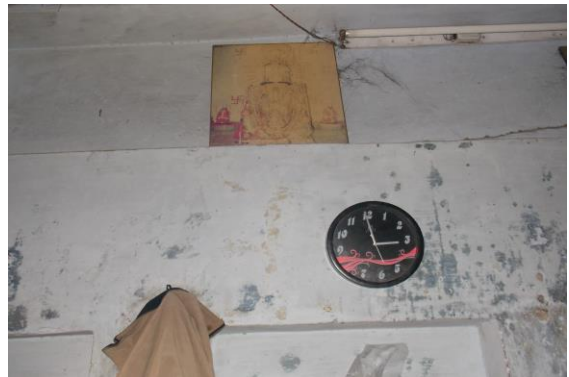
Photo 8

Dampness/Seepage on Wall No. 4 of Room No. 1 of House No. 2424 First Floor

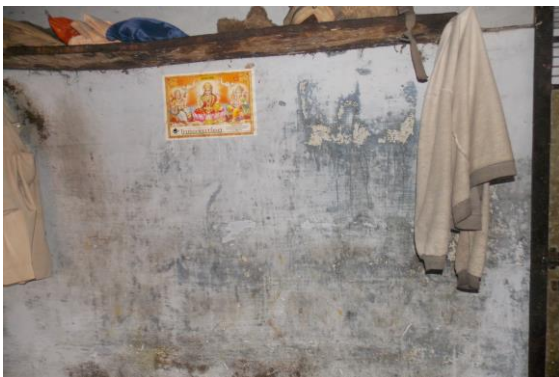
Photo 9

Dampness/Seepage on Wall No. 2 of Room No. 1 of House No. 2424 First Floor

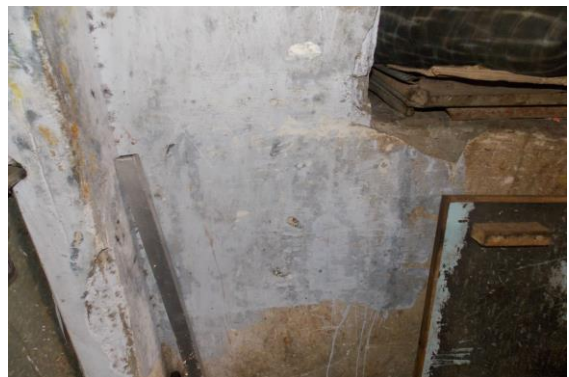
Photo 10

Peeling of Plaster on Wall No. 3 of Room No. 1 of House No. 2424 First Floor

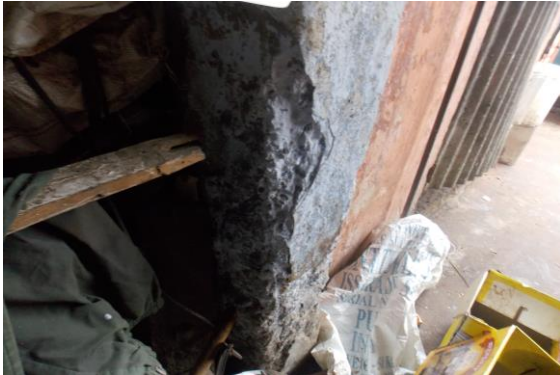
Photo 11

Peeling of Plaster on Wall No. 1 of Room No. 1 of House No. 2424 First Floor

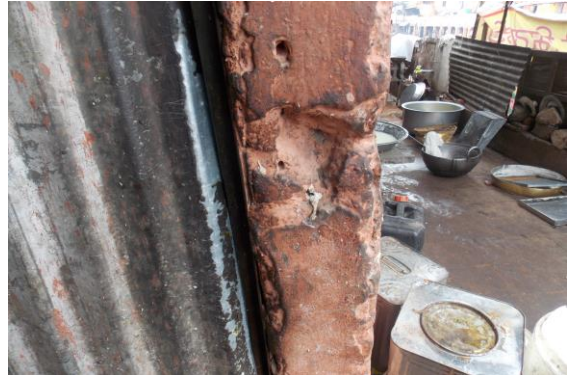
Photo 12

Peeling of Plaster on Wall No. 1 of Varandah 1 of House No. 2424 First Floor

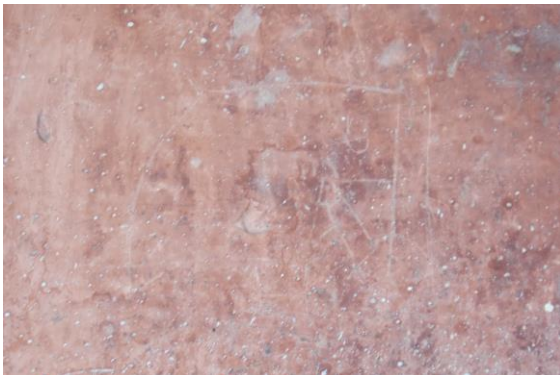
Photo 13

Peeling of Plaster on Wall No. 2 of Varandah 1 of House No. 2424 First Floor

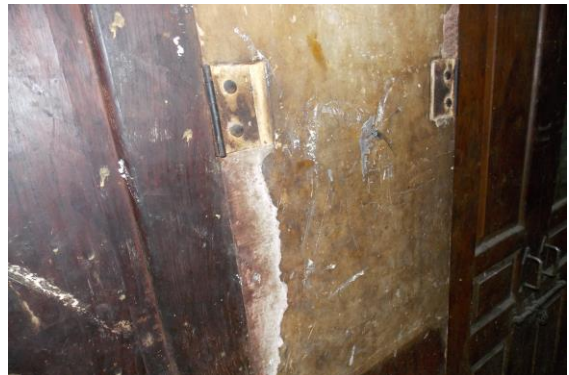
Photo 14

Peeling of Plaster on Wall No. 1 of Hall No. 1 of House No. 2424 First Floor

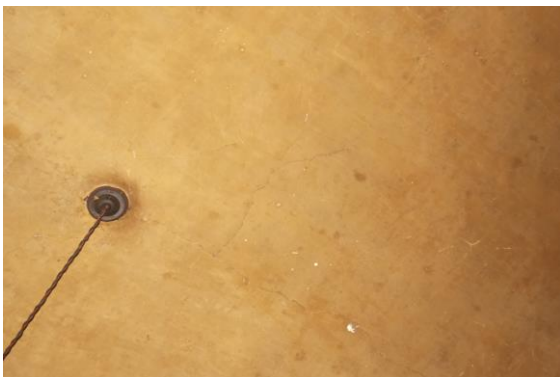
Photo 15

Peeling of Plaster on Roof of Hall No. 1 of House No. 2424 First Floor

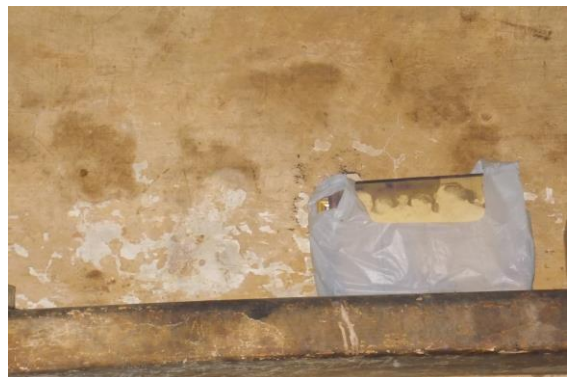
Photo 16

Peeling of Plaster on Wall No. 4 of Hall No. 1 of House No. 2424 First Floor

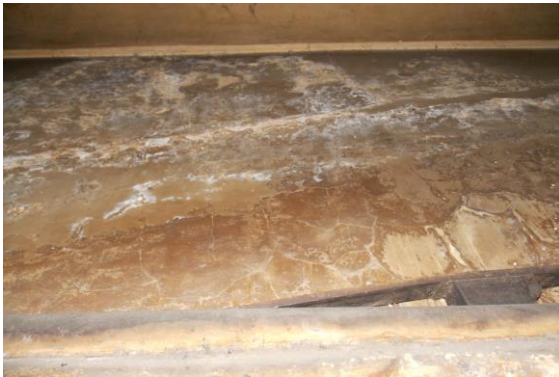
Photo 17

Dampness/Seepage on Wall No. 3 of Hall No. 1 of House No. 2424 First Floor

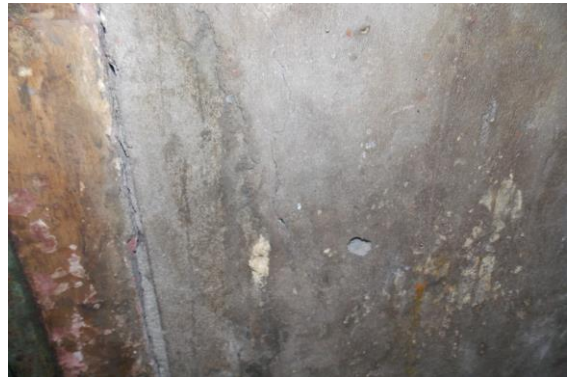
Photo 18

Peeling of Plaster on Wall No. 3 of Hall No. 1 of House No. 2424 First Floor

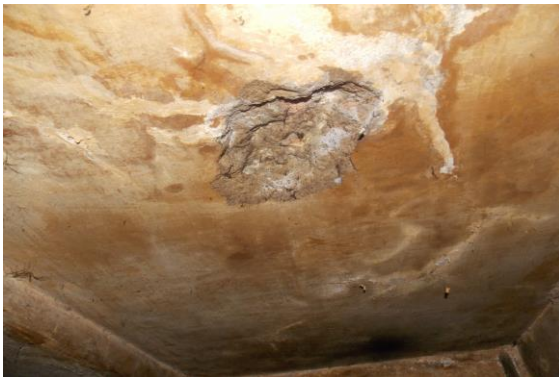
Photo 19

Peeling of Plaster on Roof of Bathroom of House No. 2424 First Floor

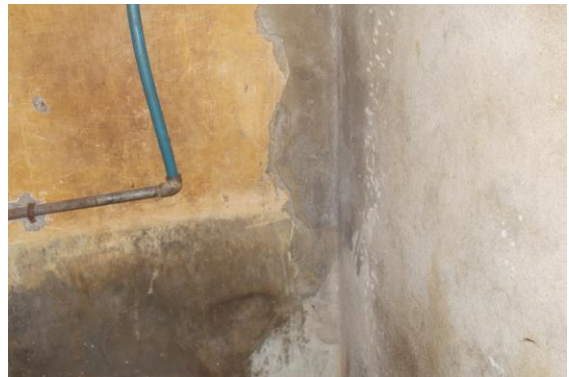
Photo 20

Peeling of Plaster on Wall No. 4 of Toilet No. 2 of House No. 2424 First Floor

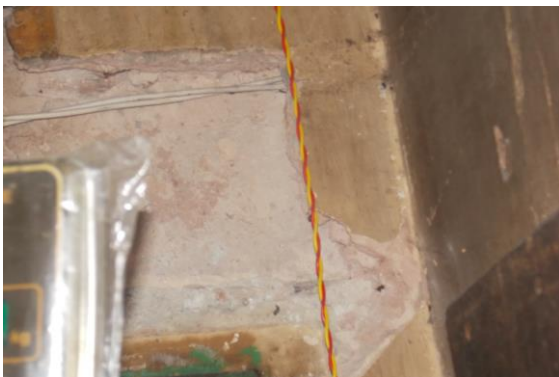
Photo 21

Peeling of Plaster on Wall No. 2 of Hall No. 1 of House No. 2424 First Floor

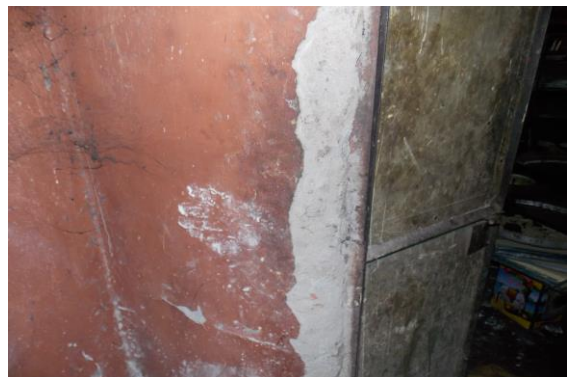
Photo 22

Peeling of Plaster on Hall No. 1 of House No. 2424 First Floor

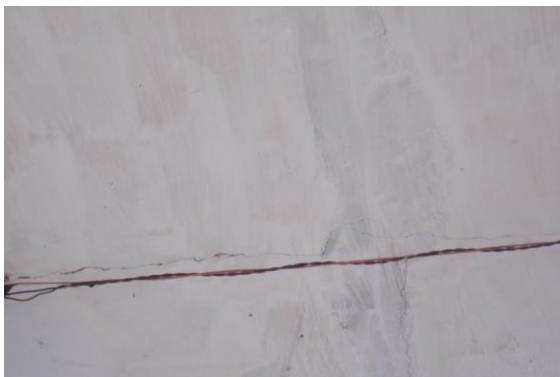
Summary of Cracks						
Defect ID	Location	Orientation	Appx. Width (mm)	Appx. Length (m)	Category	Photo No.
1	Roof Varanda of Shop No.286 Ground Floor	Horizontal	0.35	2	Very Slight	11
2	External Beam Varanda of Shop No.286 Ground Floor	Inclined	2.5	3	Slight	12

Photo 11  
Horizontal Crack on Roof of Varanda of Shop No.286, Ground Floor  
Approx. Width = 0.35mm, Approx. Length = 2m.  
Distance from Leftside External Column = Backsidem, Height from Floor = 3.5m.

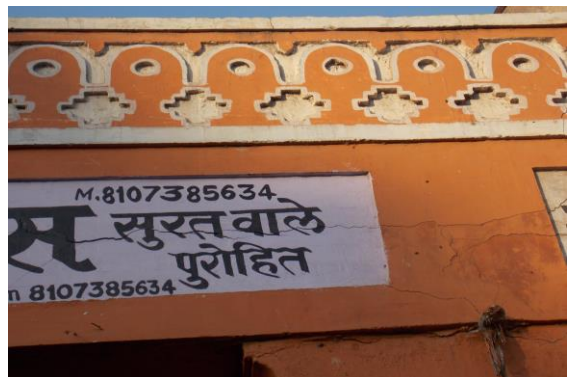
Photo 12  
Inclined Crack on External Beam of Varanda of Shop No.286, Ground Floor  
Approx. Width = 2.5mm, Approx. Length = 3m.  
Heiht from Floor = 3.5m.
