### Pre Building Condition Survey Report

Name and Address of Structure :	Badi Chopar to Ramp Area (UP Line)
---------------------------------	------------------------------------

Name of the Project	<b>Contract JMRC-UG1B</b> “Design and Construction of Tunnel between Chandpole and Badi Chouper and reverse line by Shield TBM, Underground Metro Stations at Choti Chouper and Badi Chouper by Cut and Cover Methods on East West Corridor of Jaipur Metro Rail Corporation Limited .”	
Owner :

Pre Building Condition Survey Report Badi Chopar to Ramp Area (UP Line)

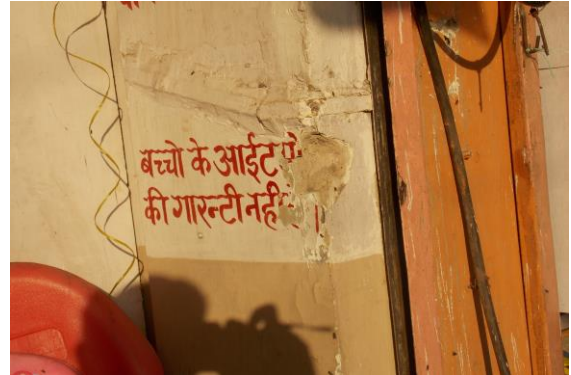
Photo 14

Summary of Defects Other Than Crack			
Defect ID	Location	Description	Photo No.
3	Roof Shop No.289 Ground Floor	Peeling of Plaster	13
4	Wall No. 2 Shop No.289 Ground Floor	Peeling of Plaster	14
5	Roof Varanda of Shop No.287 Ground Floor	Peeling of Plaster	15
6	Roof Shop No.286 Basement No.1	Peeling of Plaster	16

Peeling of Plaster on Wall No. 2 of Shop No.289 of Ground Floor

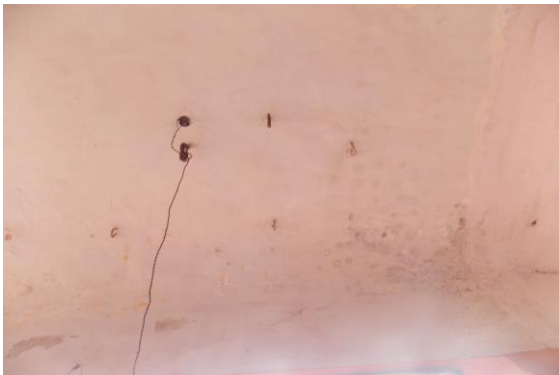
Photo 15

Peeling of Plaster on Roof of Varanda of Shop No.287 of Ground Floor

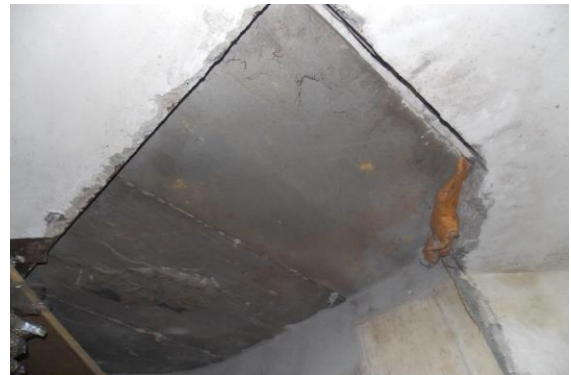
Photo 16

Peeling of Plaster on Roof of Shop No.286 of Basement No.1

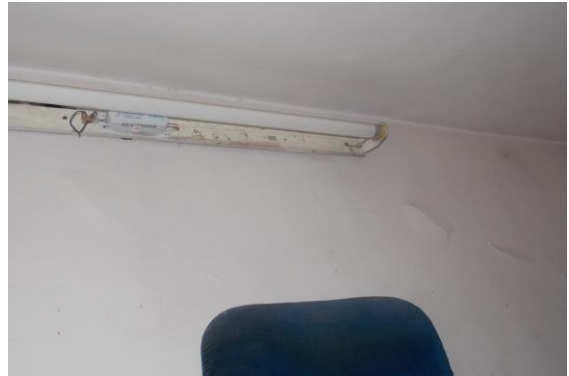
Photo 8  
Peeling of Plaster on Wall No. 1 of Hall No. 1 of House No. 2414 First Floor

Summary of Defects Other Than Crack			
Defect ID	Location	Description	Photo No.
1	Wall No. 1 Hall No. 1 House No. 2414 First Floor	Peeling of Plaster	8
2	Wall No. 2 Hall No. 1 House No. 2414 First Floor	Peeling of Plaster	9
3	Wall No. 1 Hall No. 2 House No. 2414 First Floor	Peeling of Plaster	10
4	Wall No. 6 Hall No. 2 House No. 2414 First Floor	Peeling of Plaster	11
5	Wall No. 1 Room No. 1 House No. 2414 First Floor	Peeling of Plaster	12
6	Roof Room No. 1 House No. 2414 First Floor	Peeling of Plaster	13
7	Wall No. 1 Stair FF to SF House No. 2414 First Floor	Peeling of Plaster	14
8	Wall No. 4 Stair FF to SF House No. 2414 First Floor	Peeling of Plaster	15
9	Roof Hall No. 1 House No. 2414 Second Floor	Peeling of Plaster	16
10	Wall No. 2, 4 & 6 Room No. 1 House No. 2414 Second Floor	Dampness/Seepage	17
11	Hall No. 1 House No. 2414 Second Floor	Damaged Portion	18
12	Hall No. 1 House No. 2414 Second Floor	Damaged Portion	19

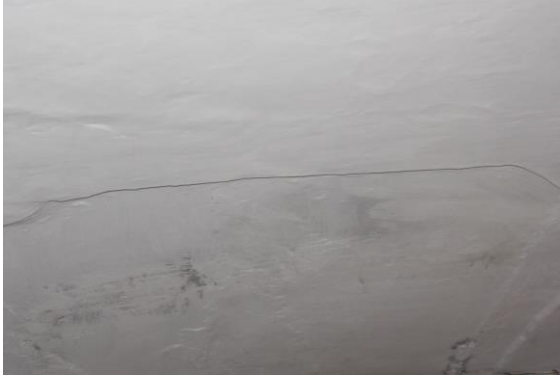
Photo 13

Peeling of Plaster on Roof of Room No. 1 of House No. 2414 First Floor

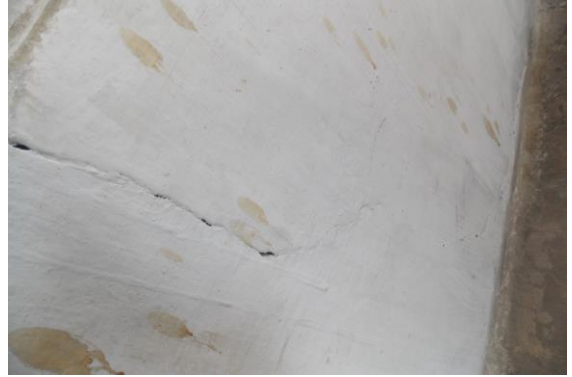
Photo 14

Peeling of Plaster on Wall No. 1 of Stair FF to SF of House No. 2414 First Floor

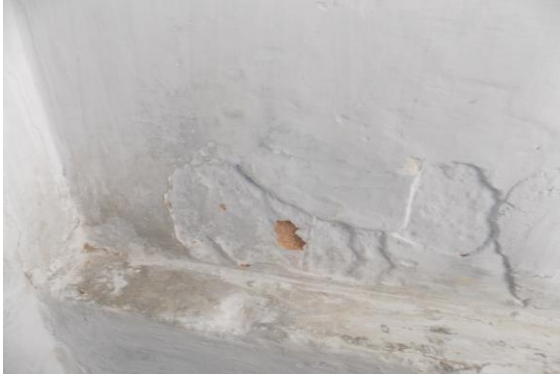
Photo 15

Peeling of Plaster on Wall No. 4 of Stair FF to SF of House No. 2414 First Floor

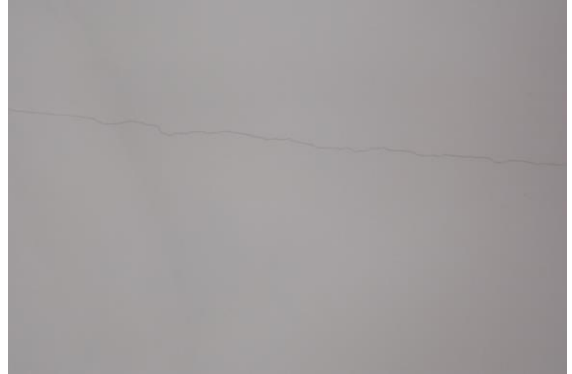
Photo 16

Peeling of Plaster on Roof of Hall No. 1 of House No. 2414 Second Floor

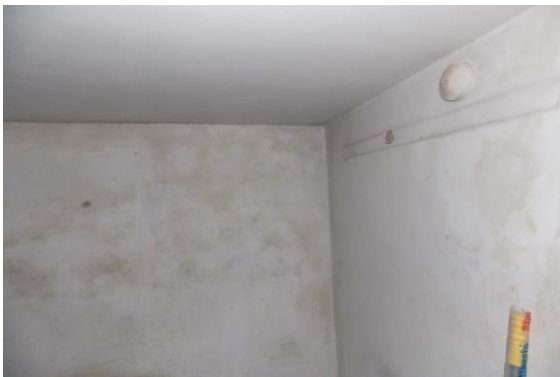
Photo 17

Dampness/Seepage on Wall No. 2, 4 & 6 of Room No. 1 of House No. 2414 Second Floor

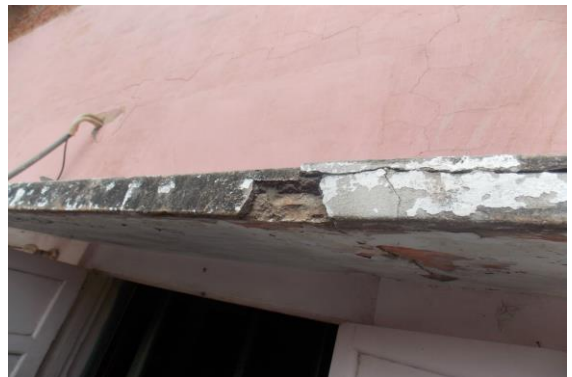
Photo 18

Damaged Portion on of Hall No. 1 of House No. 2414 Second Floor

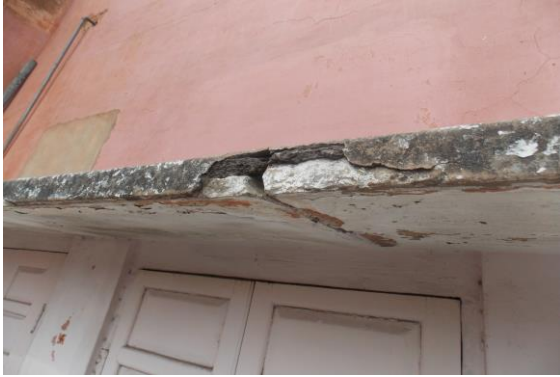
Photo 19

Damaged Portion on of Hall No. 1 of House No. 2414 Second Floor

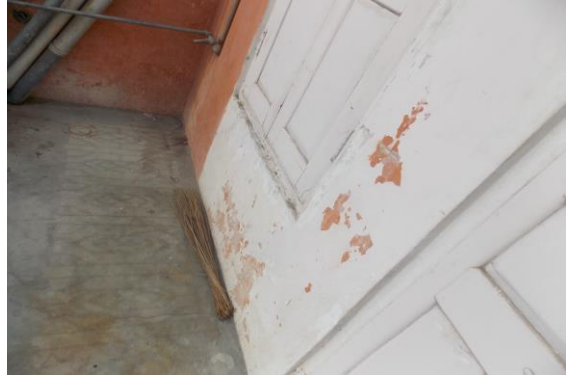
Photo 20

13	Wall No. 2 Balcony House No. 2414 Second Floor	Peeling of Plaster	20
14	Floor Balcony House No. 2414 Second Floor	Peeling of Plaster	21
15	Wall No. 1 Stair SF to TF House No. 2414 Second Floor	Peeling of Plaster	22
16	Wall No. 1 & 4 Kitchen House No. 2414 Third Floor	Peeling of Plaster	23
17	Stair SF to TF House No. 2414 Third Floor	Damaged Portion	24

Peeling of Plaster on Wall No. 2 of Balcony of House No. 2414 Second Floor

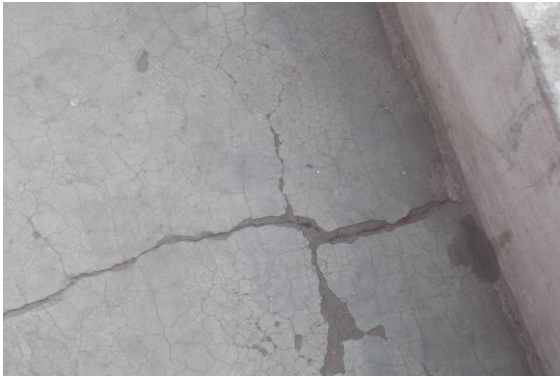
Photo 21

Peeling of Plaster on Floor of Balcony of House No. 2414 Second Floor

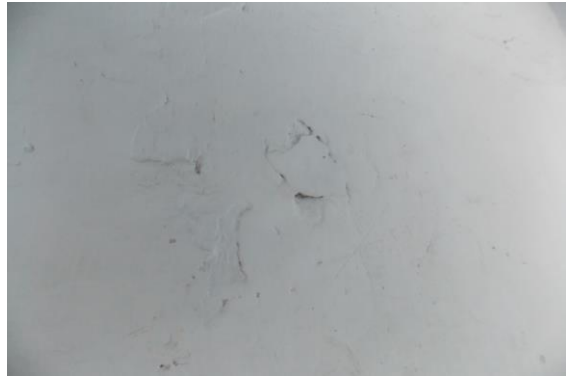
Photo 22

Peeling of Plaster on Wall No. 1 of Stair SF to TF of House No. 2414 Second Floor

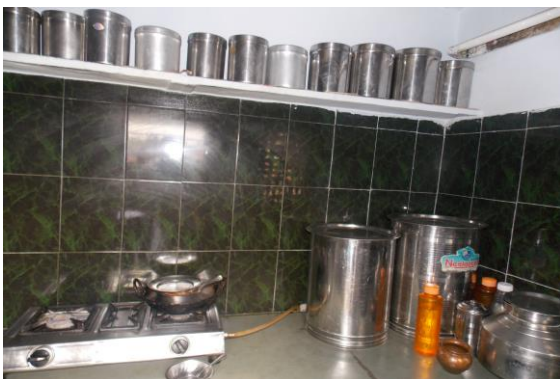
Photo 23

Peeling of Plaster on Wall No. 1 & 4 of Kitchen of House No. 2414 Third Floor

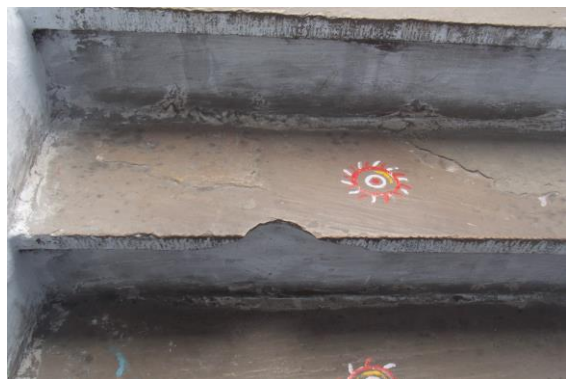
Photo 24

Damaged Portion on of Stair SF to TF of House No. 2414 Third Floor

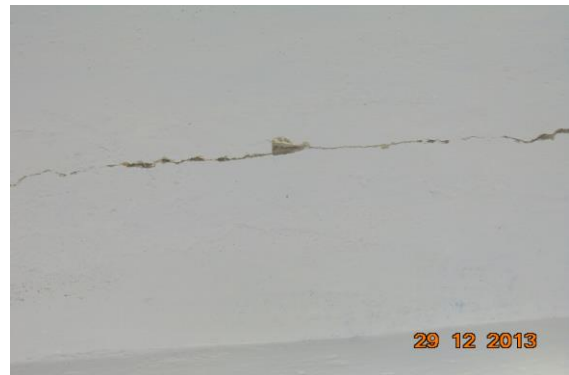
The average width of cracks is 0.5mm and average length of cracks is 2m. The maximum crack width is 0.5mm and minimum width is 0.5mm.

Summary of Cracks						
Defect ID	Location	Orientation	Appx. Width (mm)	Appx. Length (m)	Category	Photo No.
1	Roof House No. 2405 to 2408 First Floor	Horizontal	0.5	2	Very Slight	10

Photo 10  
Horizontal Crack on Roof of House No. 2405 to 2408, First Floor  
Approx. Width = 0.5mm, Approx. Length = 2m.  
Distance from Wall No. 3 = 0.2m, Height from Floor = 2.5m.

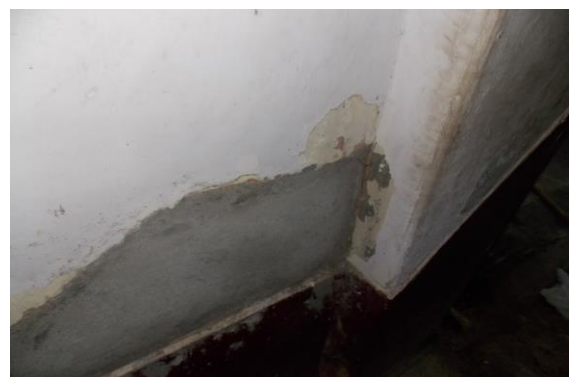
Summary of Defects Other Than Crack			
Defect ID	Location	Description	Photo No.
2	Wall No. Floor Hall No. 1 House No. 2405 to 2408, Ground Floor	Peeling of Plaster	11
3	Wall No. 1 Passage 1 of House No. 2405 to 2408 Ground Floor	Peeling of Plaster	12
4	Roof Varanda 2 of House No. 2405 to 2408 Ground Floor	Dampness/Seepage	13
5	Wall No. 1 Passage 2 of House No. 2405 to 2408 Ground Floor	Peeling of Plaster	14
6	Roof & 4 Toilet No. 4 House No. 2405 to 2408, Ground Floor	Dampness/Seepage	15
7	Wall No. 5 & 7 Passage 2 of House No. 2405 to 2408 Ground Floor	Dampness/Seepage	16
8	Roof Passage 2 of House No. 2405 to 2408 Ground Floor	Peeling of Plaster	17
9	All wall Room No. 28 House No. 2405 to 2408, Ground Floor	Peeling of Plaster	18
10	All wall Room No. 27 House No. 2405 to 2408, Ground Floor	Peeling of Plaster	19
11	Wall No. 4 Bathroom No. House No. 2405 to 2408, Ground Floor	Peeling of Plaster	20
12	Wall No. 2 & 4 Varanda 5 of House No. 2405 to 2408 Ground Floor	Dampness/Seepage	21

Photo 12  
Peeling of Plaster on Wall No. 1 of Passage 1 of House No. 2405 to 2408 of Ground Floor

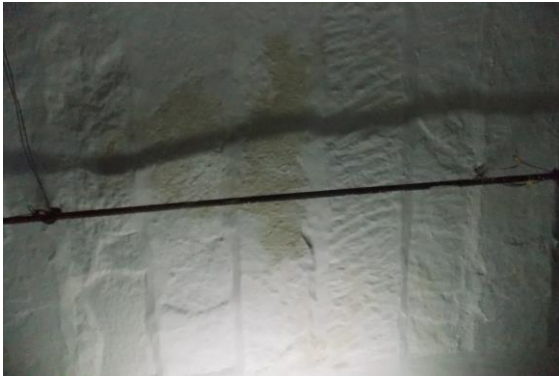
Photo 13

Dampness/Seepage on Roof of Varanda 2 of House No. 2405 to 2408 of Ground Floor

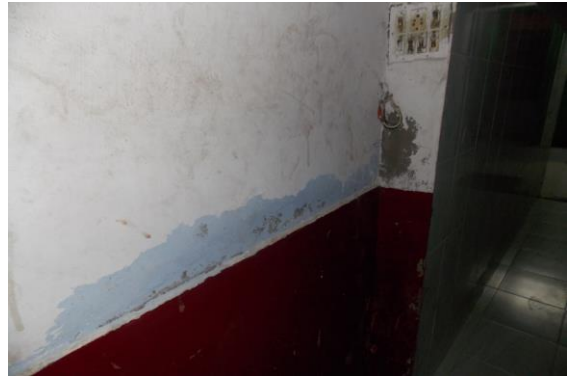
Photo 14

Peeling of Plaster on Wall No. 1 of Passage 2 of House No. 2405 to 2408 of Ground Floor

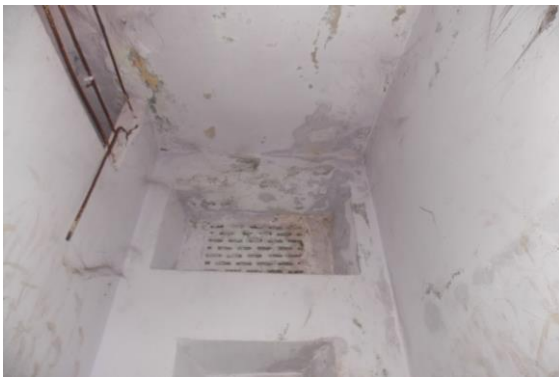
Photo 15

Dampness/Seepage on Wall No.4 & Roof of Toilet No. 4 of House No. 2405 to 2408, Ground Floor

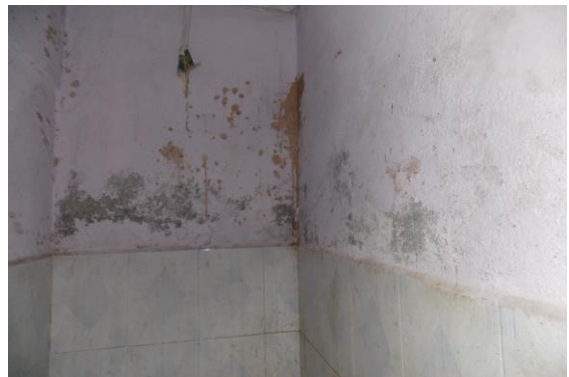
Photo 16

Dampness/Seepage on Wall No. 5 & 7 of Passage 2 of House No. 2405 to 2408 of Ground Floor

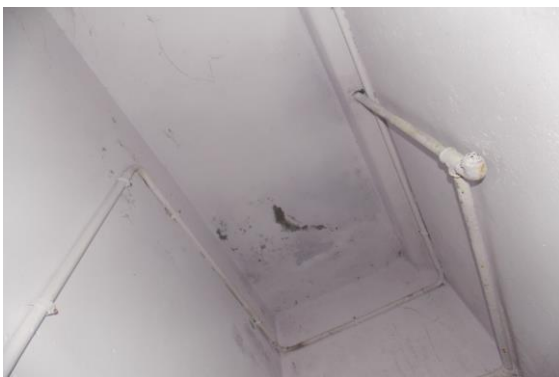
Photo 17

Peeling of Plaster on Roof of Passage 2 of House No. 2405 to 2408 of Ground Floor

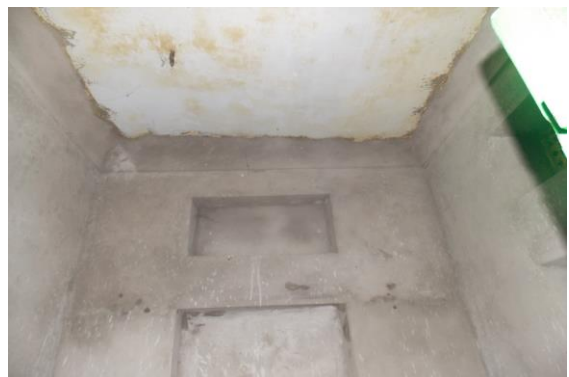
Photo 18

Peeling of Plaster on All wall of Room No. 28 of House No. 2405 to 2408, Ground Floor

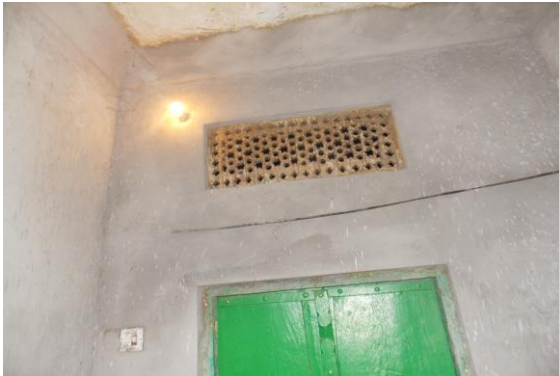
Photo 19

Peeling of Plaster on All wall of Room No. 27 of House No. 2405 to 2408, Ground Floor

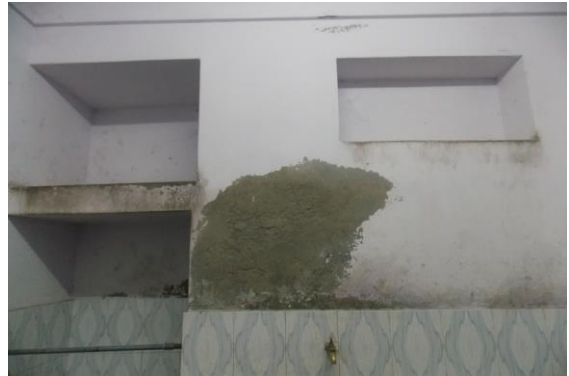
Photo 20

Peeling of Plaster on Wall No. 4 of Bathroom No. of House No. 2405 to 2408, Ground Floor

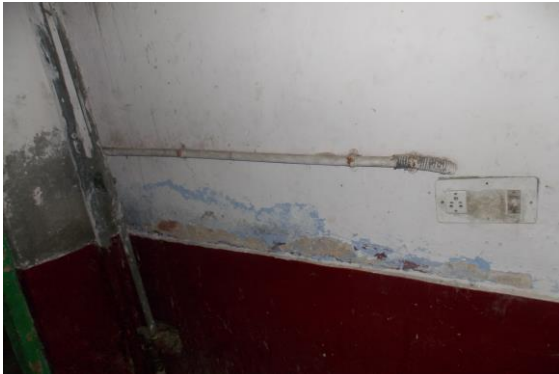
Photo 21

Dampness/Seepage on Wall No. 2 & 4 of Varanda 5 of House No. 2405 to 2408 of Ground Floor

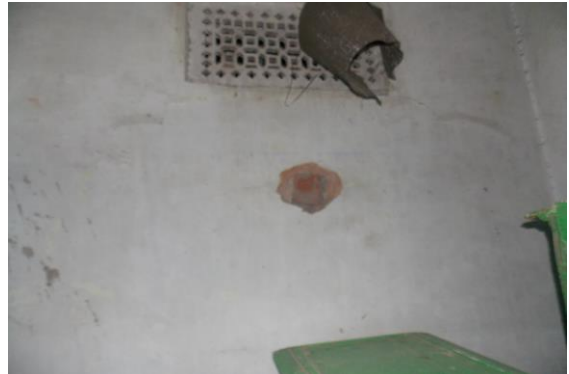
Photo 22

Peeling of Plaster on Wall No. 1 of Room No. 25 of House No. 2405 to 2408, Ground Floor

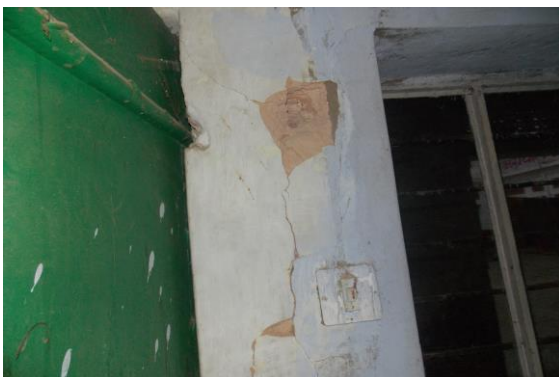
Photo 23

Damaged Portion on Wall No. 3 of Room No. 25 of House No. 2405 to 2408, Ground Floor

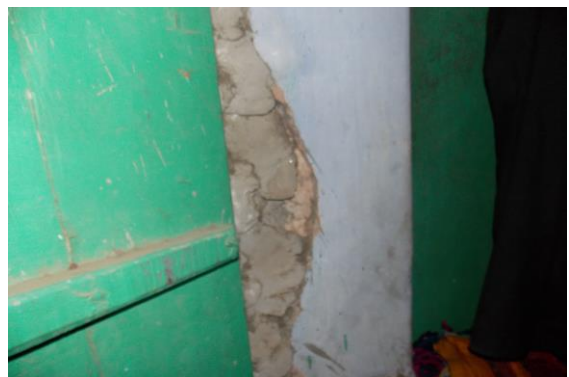
Photo 24

Peeling of Plaster on Wall No. 1 of Store Room of House No. 2405 to 2408 of Ground Floor

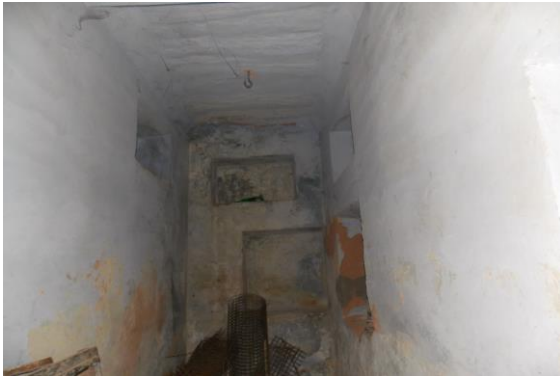
Photo 25

Dampness/Seepage on Wall No. 1, 2 & 4 of Room No. 21 of House No. 2405 to 2408, Ground Floor

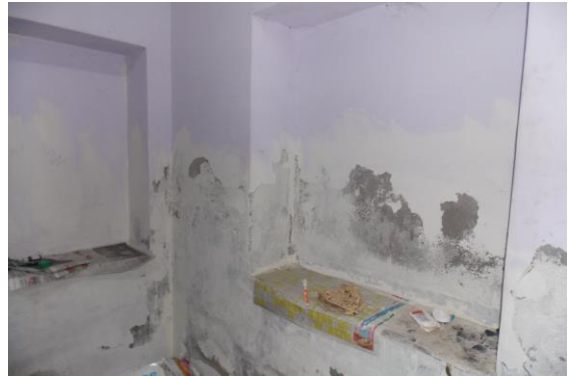
Photo 26

Peeling of Plaster on Wall No. 2 & 4 of Room No. 20 of House No. 2405 to 2408, Ground Floor

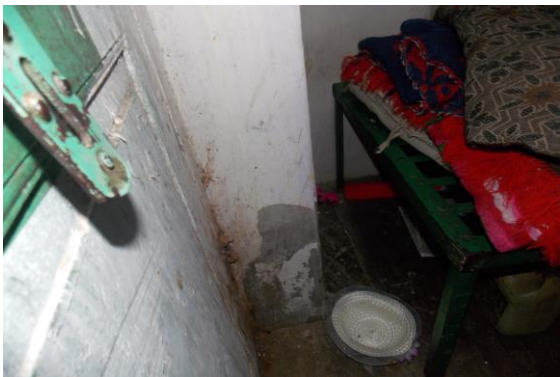
Photo 27

Peeling of Plaster on Wall No. 1 of Room No. 20 of House No. 2405 to 2408, Ground Floor

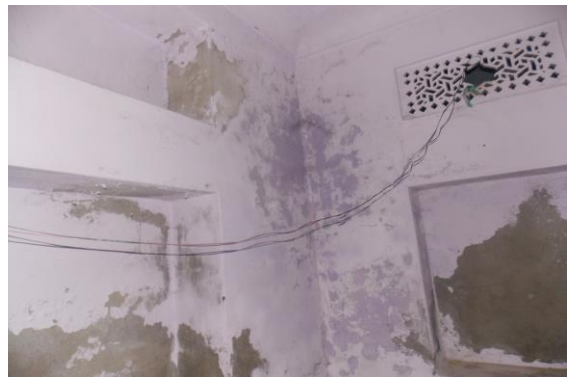
Photo 28

Dampness/Seepage on Wall No. 1 & 4 of Room No. 19 of House No. 2405 to 2408, Ground Floor

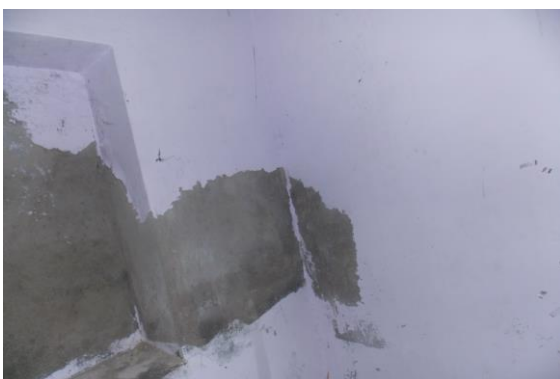
Photo 29

Peeling of Plaster on Wall No. 2 of Room No. 19 of House No. 2405 to 2408, Ground Floor

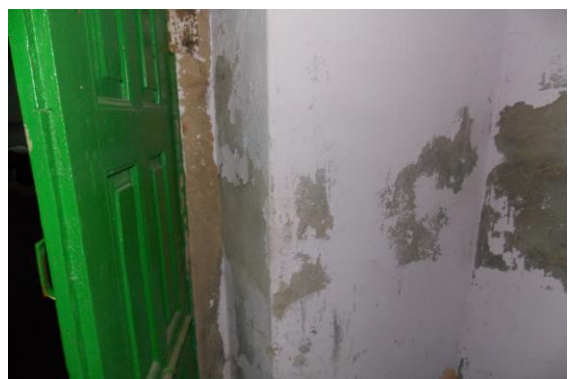
Photo 30

Peeling of Plaster on Wall No. 3 of Room No. 19 of House No. 2405 to 2408, Ground Floor

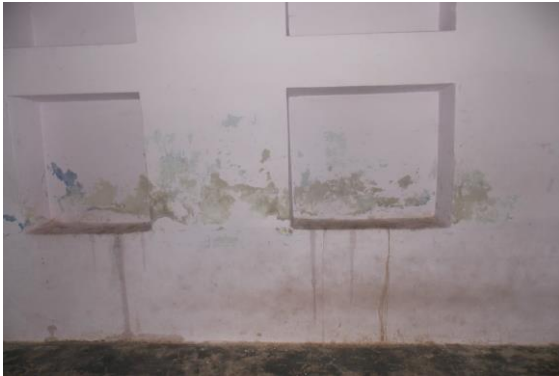
Photo 31

Peeling of Plaster on Wall No. 4 of Hall No. 3 of House No. 2405 to 2408, Ground Floor

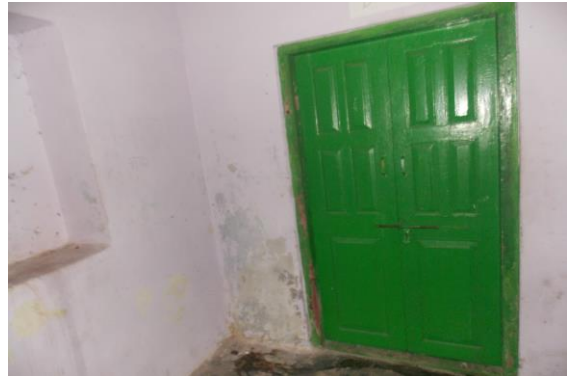
Photo 32

Peeling of Plaster on Wall No. 2 of Hall No. 2 of House No. 2405 to 2408, Ground Floor

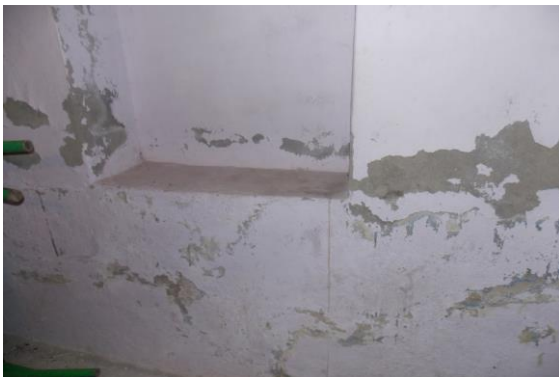
Photo 33

Peeling of Plaster on Wall No. 2 of Room No. 18 of House No. 2405 to 2408, Ground Floor

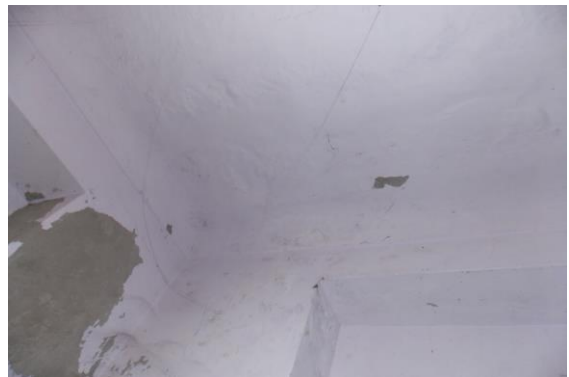
Photo 34

Peeling of Plaster on Wall No. 4 & Roof of Room No. 18 of House No. 2405 to 2408, Ground Floor

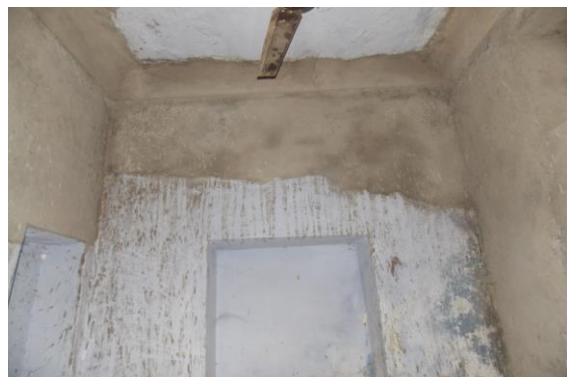
Photo 36

Peeling of Plaster on All wall of Room No. 16 of House No. 2405 to 2408, Ground Floor

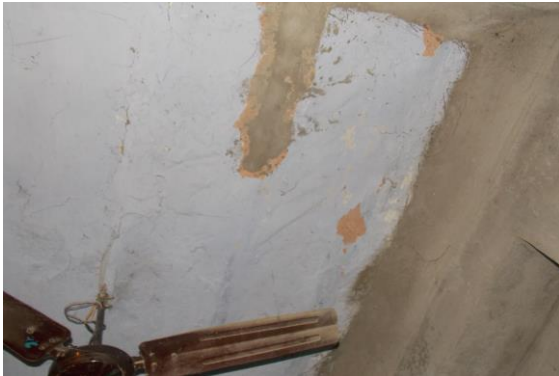
Photo 37

Peeling of Plaster on Roof of Room No. 16 of House No. 2405 to 2408, Ground Floor

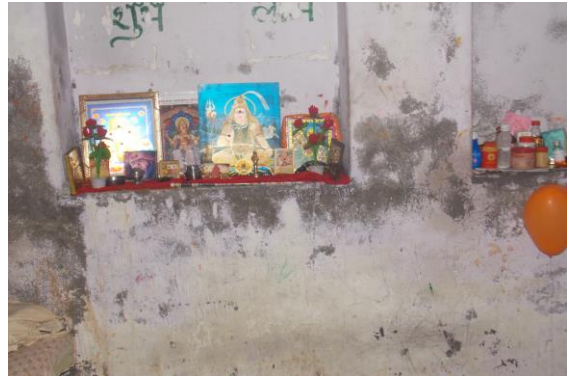
Photo 38

Peeling of Plaster on Wall No. 4 of Room No. 11 of House No. 2405 to 2408, Ground Floor

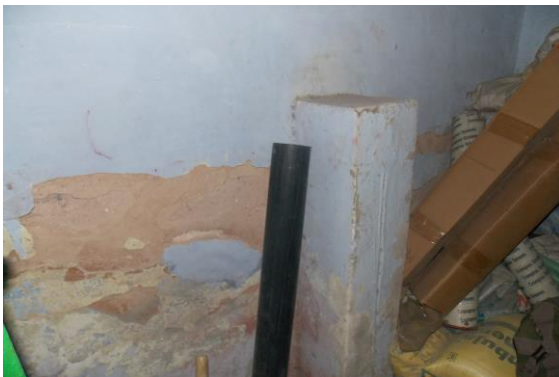
Photo 39

Peeling of Plaster on Wall No. 1 of Room No. 10 of House No. 2405 to 2408, Ground Floor

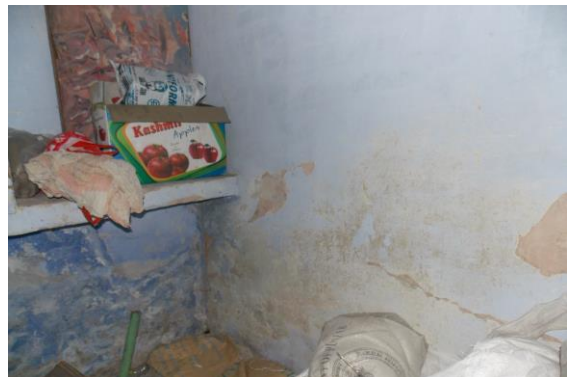
Photo 40

Peeling of Plaster on Wall No. 2 of Room No. 10 of House No. 2405 to 2408, Ground Floor

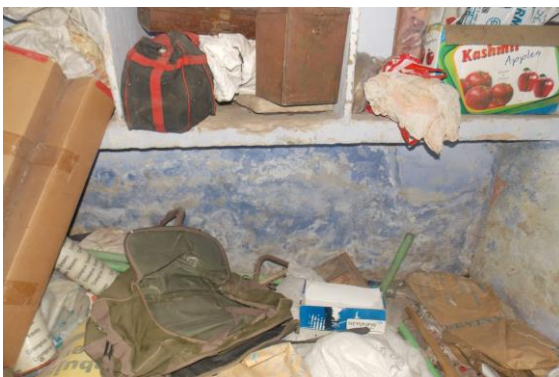
Photo 41

Dampness/Seepage on Wall No. 4 of Room No. 10 of House No. 2405 to 2408, Ground Floor

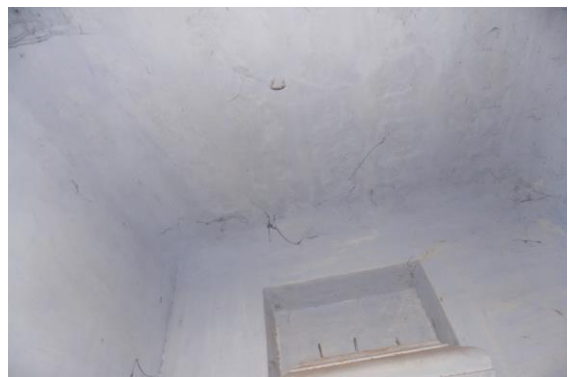
Photo 42

Dampness/Seepage on Roof of Room No. 10 of House No. 2405 to 2408, Ground Floor

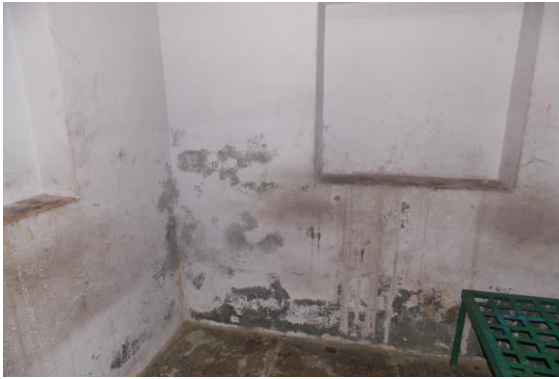
Photo 43

Peeling of Plaster on Wall No. 1 & 4 of Room No. 12 of House No. 2405 to 2408, Ground Floor

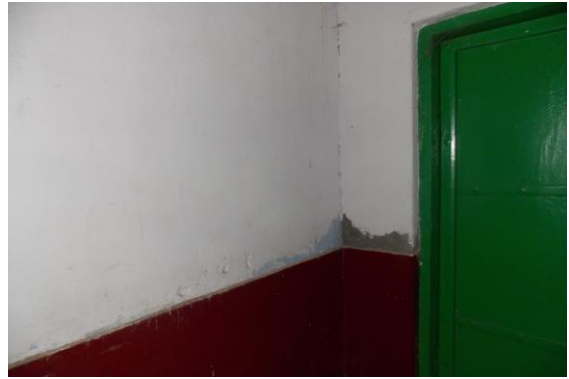
Photo 44

Peeling of Plaster on Wall No. 1 & 4 of Varanda 3 of House No. 2405 to 2408 of Ground Floor

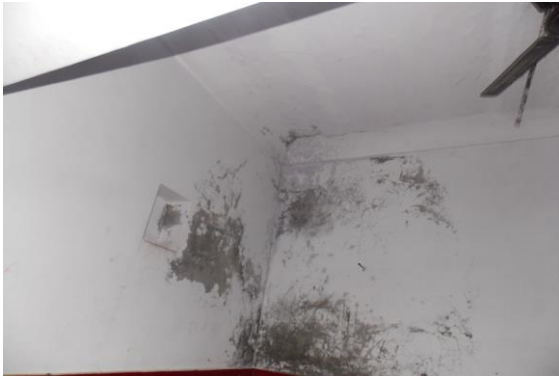
Photo 45

Peeling of Plaster on Wall No. Roof, 1 & 2 of Room No. 9 of House No. 2405 to 2408, Ground Floor

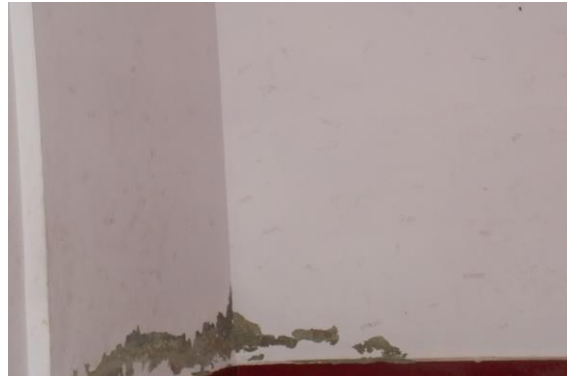
Photo 46

Peeling of Plaster on Roof & Wall No. 1 & 2 of House No. 2405 to 2408 of Ground Floor

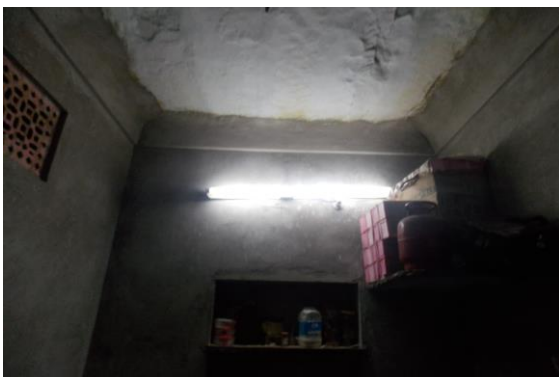
Photo 47

Peeling of Plaster on Room No. 8 of House No. 2405 to 2408, Ground Floor

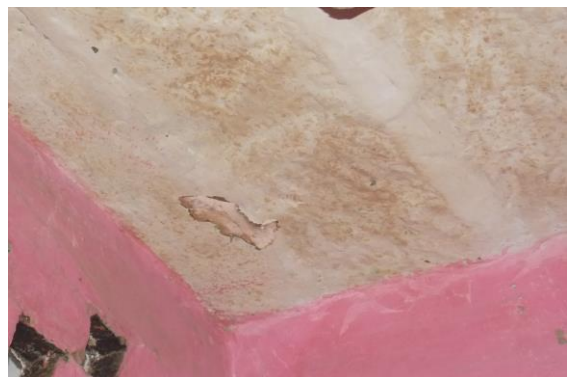
Photo 48

Peeling of Plaster on Roof of Room No. 7 of House No. 2405 to 2408, Ground Floor

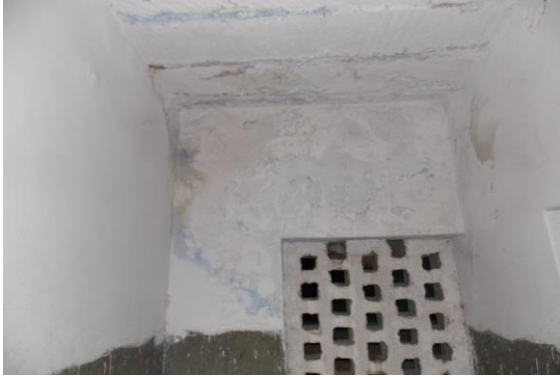
Photo 49

Dampness/Seepage on Wall No. 4 of Bathroom of House No. 2405 to 2408, Second Floor

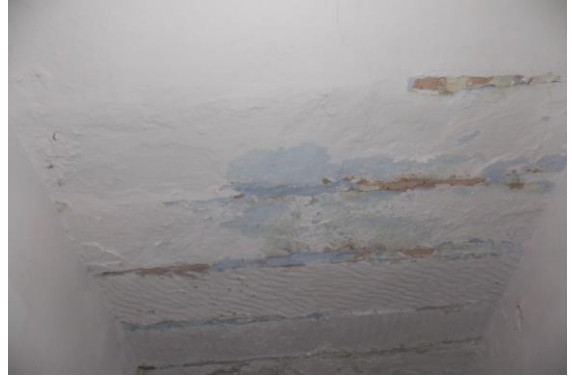
Photo 50

Peeling of Plaster on Roof of Bathroom of House No. 2405 to 2408, Second Floor

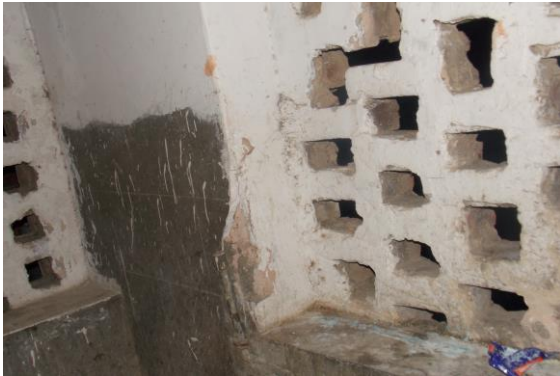
Photo 51

Peeling of Plaster on Wall No. 2 of Bathroom of House No. 2405 to 2408, Second Floor

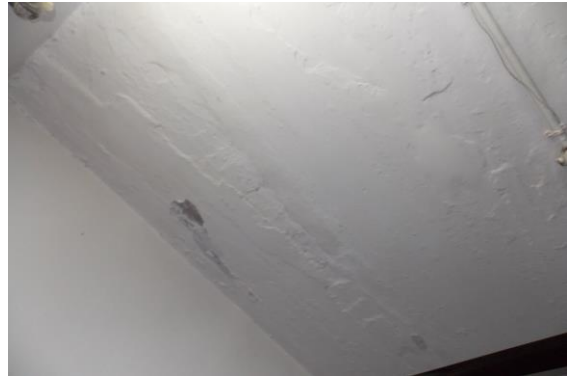
Photo 52

Peeling of Plaster on Roof of Room No. 10 of House No. 2405 to 2408, Second Floor

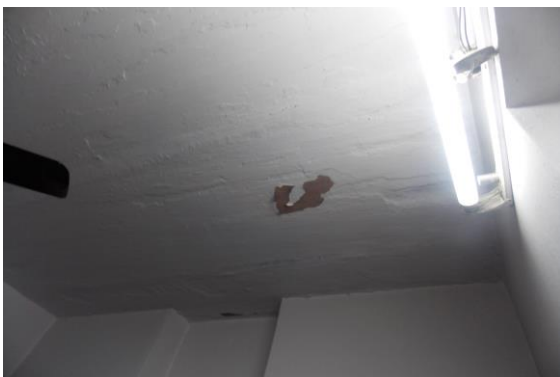
Photo 53

Peeling of Plaster on Roof of Room No. 8 of House No. 2405 to 2408, Second Floor

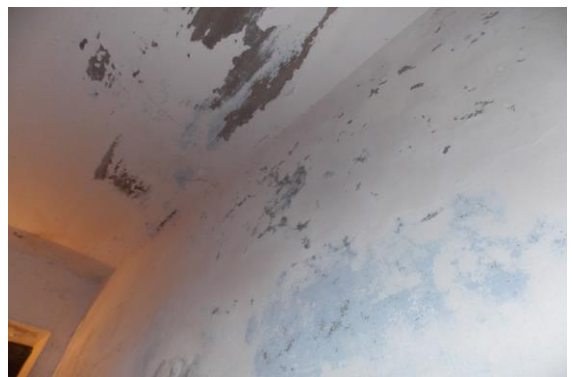
Photo 54

Dampness/Seepage on Wall No.2 & Roof of Passage 1 of House No. 2405 to 2408 of Second Floor

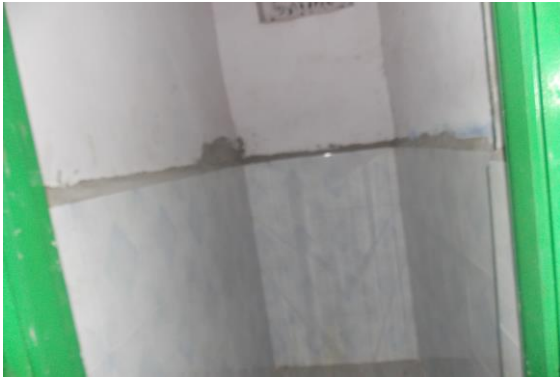
Photo 55

Dampness/Seepage on Roof of Toilet No. 1 of House No. 2405 to 2408, Second Floor

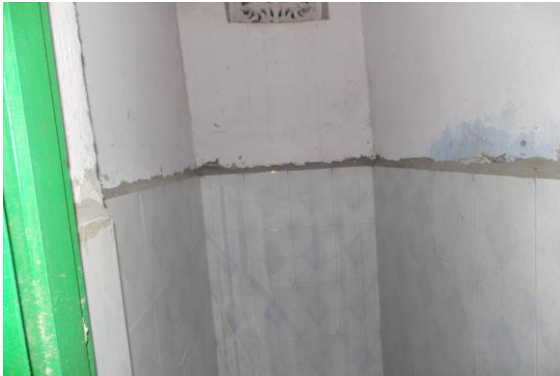
Photo 56

Dampness/Seepage on Roof of Toilet No. 2 of House No. 2405 to 2408, Second Floor

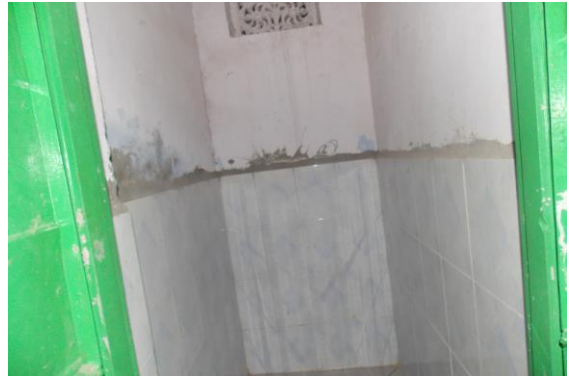
Photo 57

Dampness/Seepage on Roof of Toilet No. 3 of House No. 2405 to 2408, Second Floor

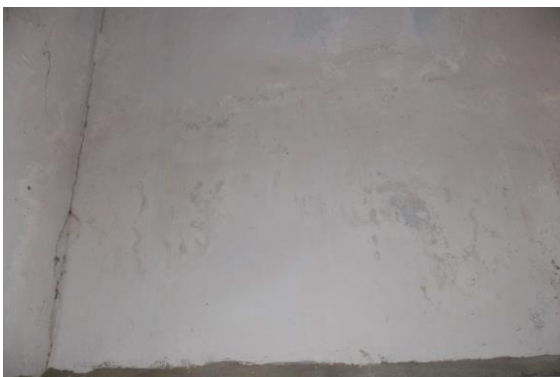
Photo 58

Dampness/Seepage on Roof of Toilet No. 4 of House No. 2405 to 2408, Second Floor

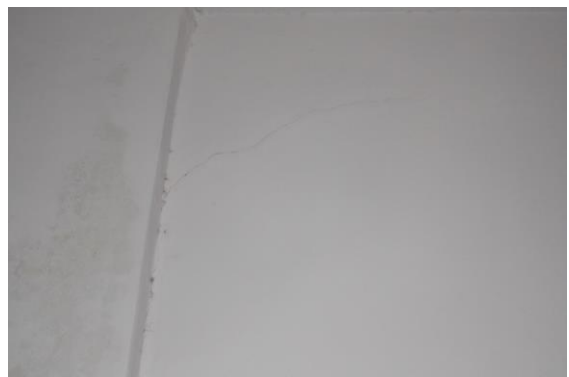
Photo 59

Dampness/Seepage on Wall No. 3 of Bathroom of House No. 2405 to 2408, Second Floor

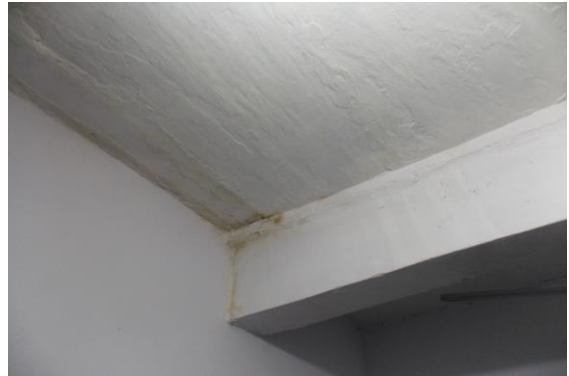
Photo 61

Peeling of Plaster on Roof of Room No. 18 of House No. 2405 to 2408, Second Floor

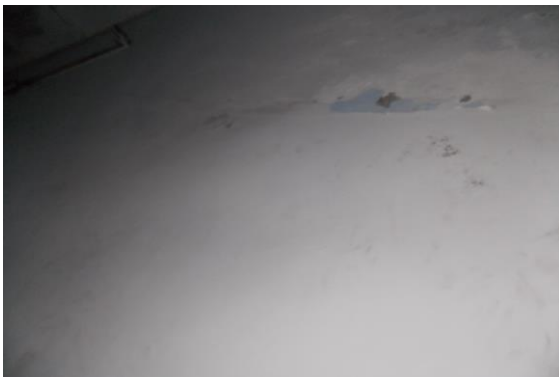
Photo 62

Dampness/Seepage on Roof of Room No. 17 of House No. 2405 to 2408, Second Floor

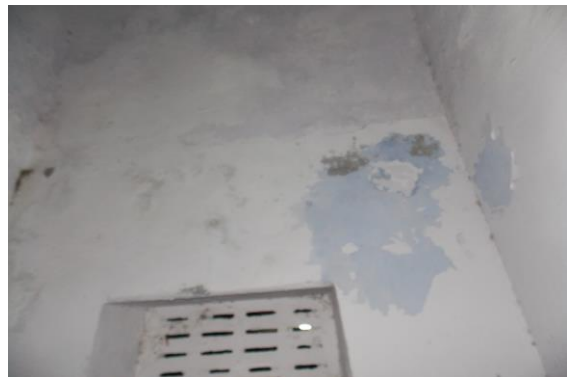
Photo 63

Peeling of Plaster on Wall No. 2 of Staircase Second Floor to Terrace of House No. 2405 to 2408 of Terrace

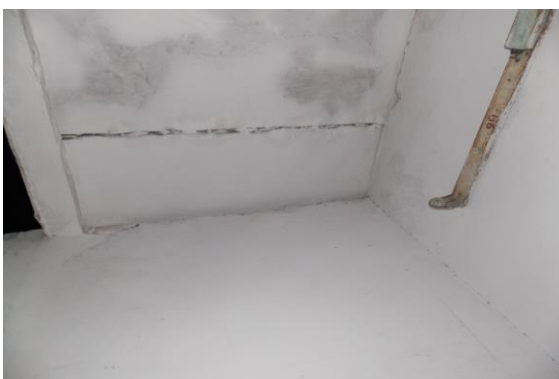
Photo 64

Peeling of Plaster on Wall No. 3 of Staircase Second Floor to Terrace of House No. 2405 to 2408 of Terrace

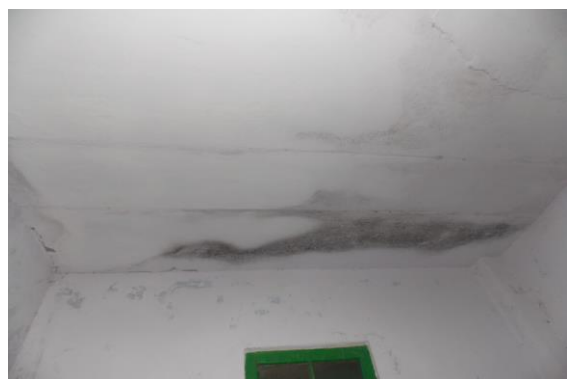
Photo 65

Dampness/Seepage on Roof of Staircase Second Floor to Terrace of House No. 2405 to 2408 of Terrace

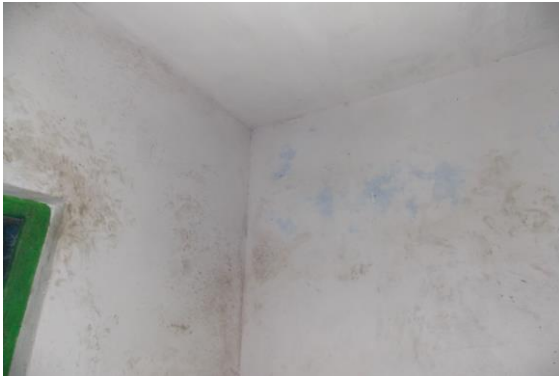
Photo 66

Dampness/Seepage on Wall No. 4 & Roof of Room No. 1 of House No. 2405 to 2408, Terrace

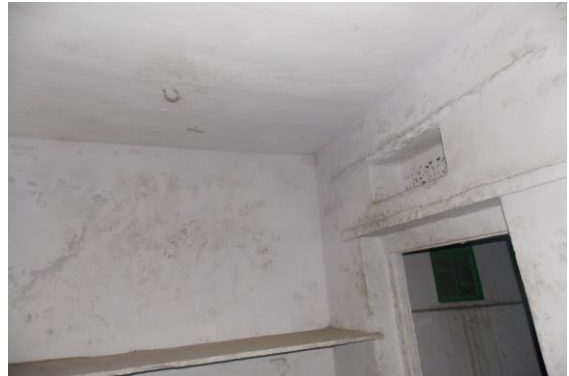
Photo 67

Dampness/Seepage on Wall No. 1 & 4 of Room No. 2 of House No. 2405 to 2408, Terrace

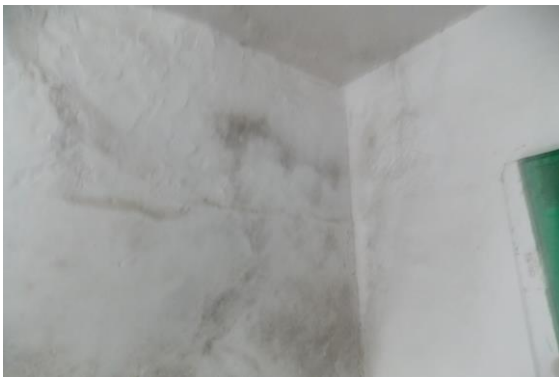
Photo 68

Dampness/Seepage on Wall No. 2 & 3 of Room No. 2 of House No. 2405 to 2408, Terrace

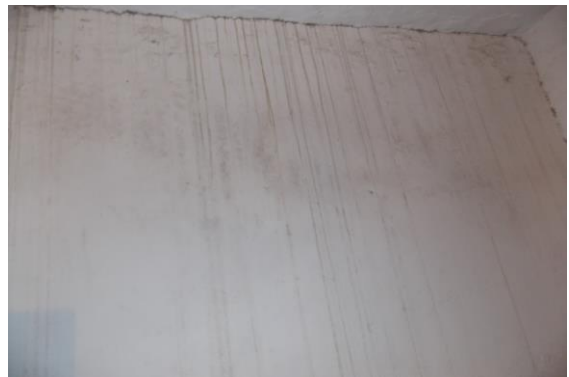
Photo 69

Dampness/Seepage on Wall No. 2 & 4 of Room No. 2 of House No. 2405 to 2408, Second Floor

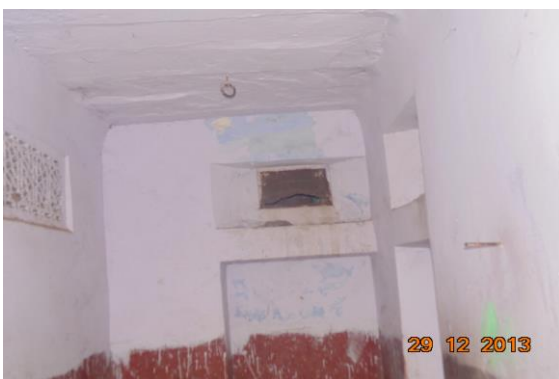
Photo 70

Dampness/Seepage on Wall No. 1 of Room No. 2 of House No. 2405 to 2408, Second Floor

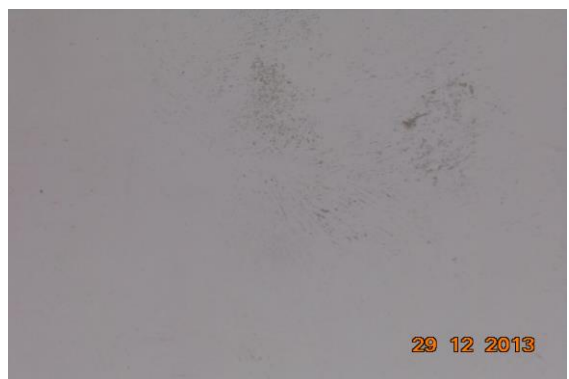
Photo 71

Dampness/Seepage on Wall No. 4 of Bathroom of House No. 2405 to 2408, First Floor

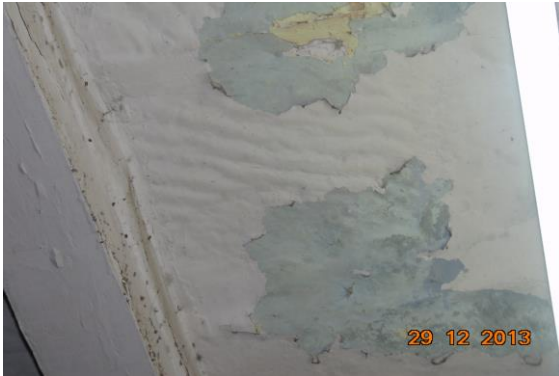
Photo 72

Peeling of Plaster on Wall No. 4 of Room No. 1 of House No. 2405 to 2408, First Floor

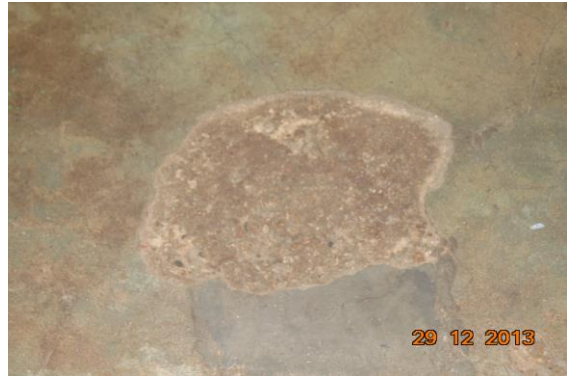
Photo 73

Peeling of Plaster on Roof of Room No. 2 of House No. 2405 to 2408, First Floor

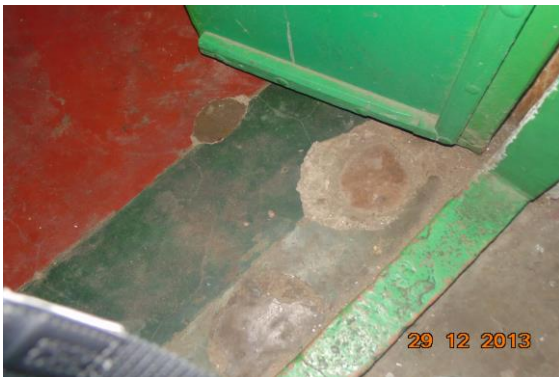
Photo 74

Peeling of Plaster on Floor of Room No. 3 of House No. 2405 to 2408, First Floor

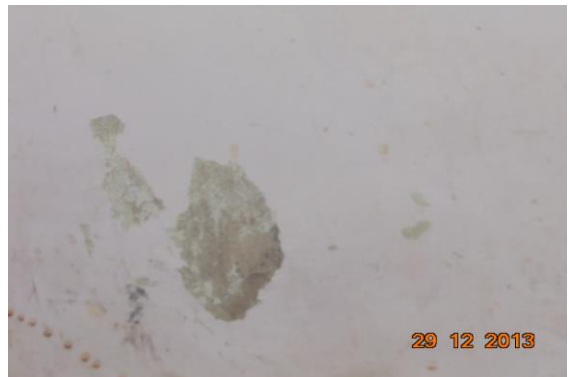
Photo 75

Damaged Portion on Floor of Room No. 6 of House No. 2405 to 2408, First Floor

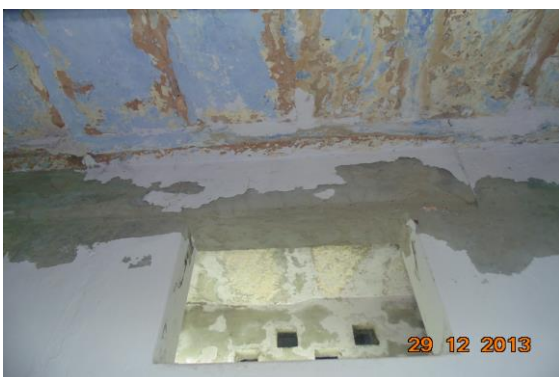
Photo 76

Peeling of Plaster on Wall No. 4 of Room No. 6 of House No. 2405 to 2408, First Floor

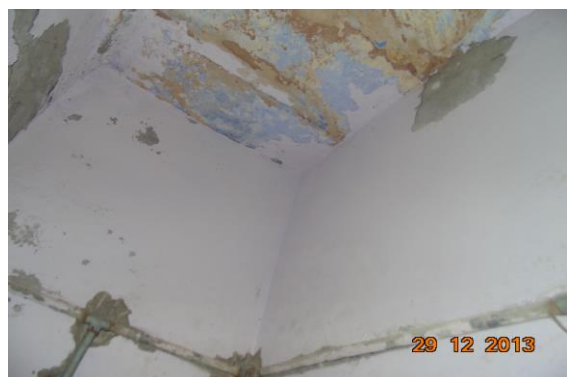
Photo 77

Dampness/Seepage on Wall No.4 & Roof of Passage 2 of Part A of House No. 2405 to 2408 of First Floor

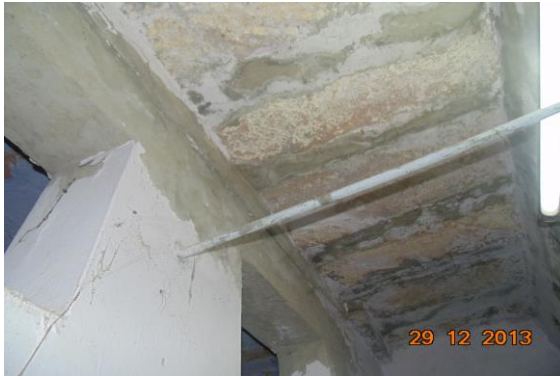
Photo 78

Dampness/Seepage on Wall No. 2 & 3 of Passage 2 of Part A of House No. 2405 to 2408 of First Floor

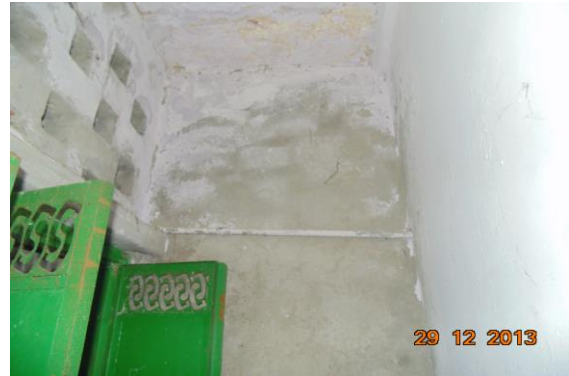
Photo 79

Dampness/Seepage on Wall No. 3 & Roof of Passage 2 of Part B of House No. 2405 to 2408 of First Floor

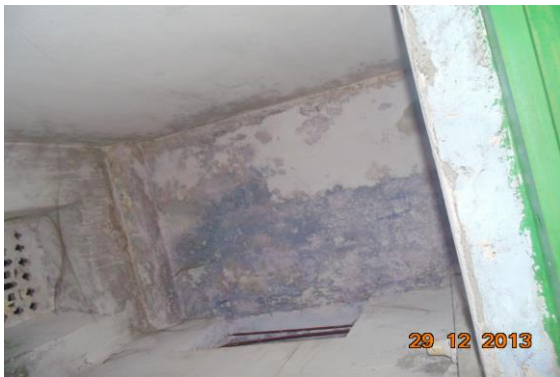
Photo 80

Dampness/Seepage on Wall No. 2 of Passage 2 of Part B of House No. 2405 to 2408 of First Floor

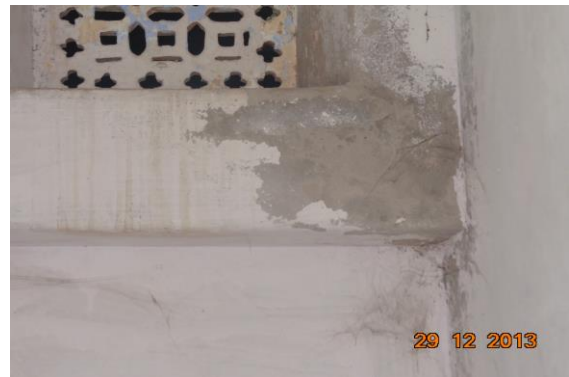
Photo 81

Dampness/Seepage on Roof of Toilet No. 1 of House No. 2405 to 2408, First Floor

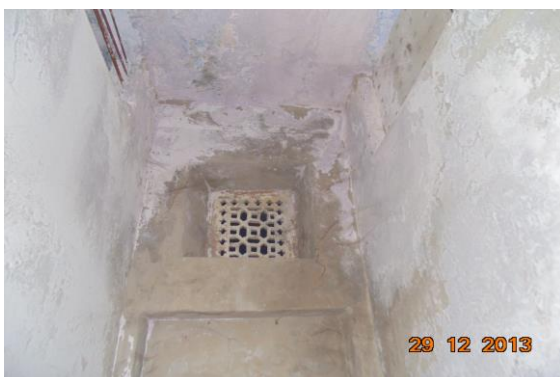
Photo 82

Peeling of Plaster on Wall No. 4 of Toilet No. 1 of House No. 2405 to 2408, First Floor

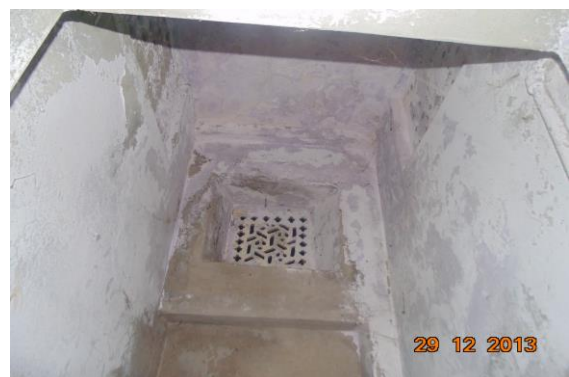
Photo 83

Dampness/Seepage on Wall No. 2,4 & Roof of Toilet No. 2 of House No. 2405 to 2408, First Floor

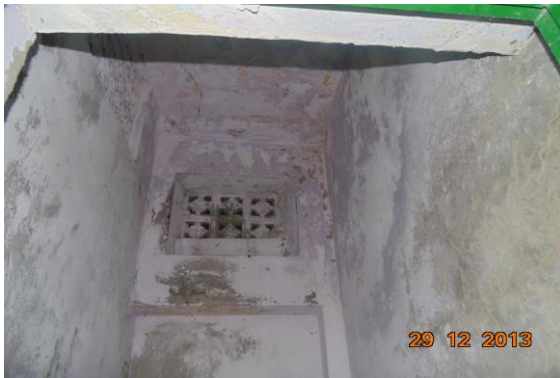
Photo 84

Dampness/Seepage on Wall No. 1,2,4 & Roof of Toilet No. 3 of House No. 2405 to 2408, First Floor

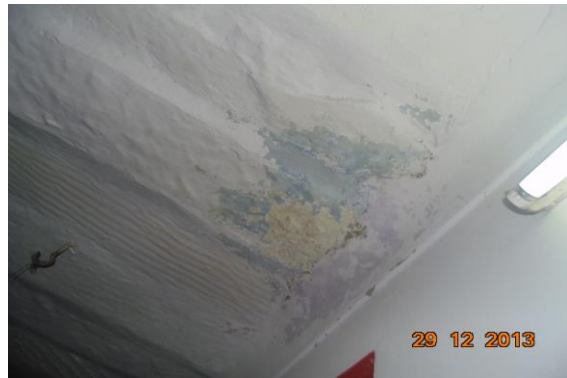
Photo 85

Dampness/Seepage on Roof & Wall No. 1, 2 & 4 of Toilet No. 4 of House No. 2405 to 2408, First Floor

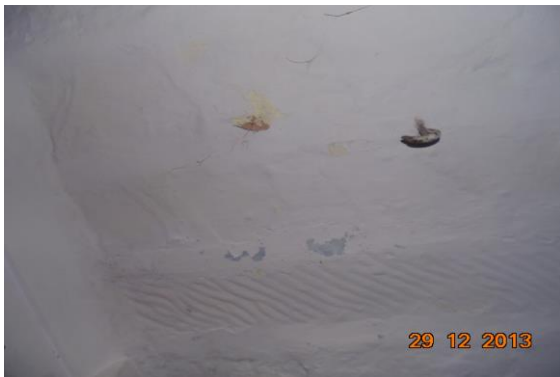
Photo 86

Dampness/Seepage on Roof of Varanda of House No. 2405 to 2408 of First Floor

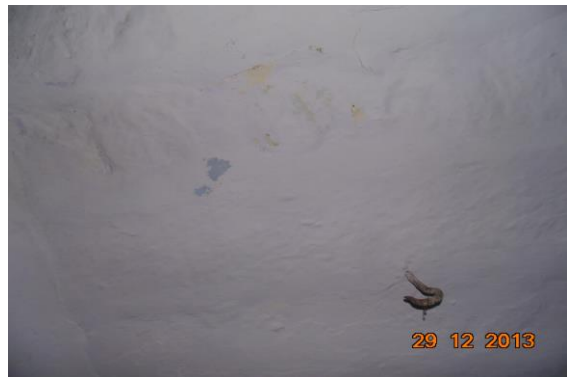
Photo 87

Dampness/Seepage on Roof of Varanda of House No. 2405 to 2408 of First Floor

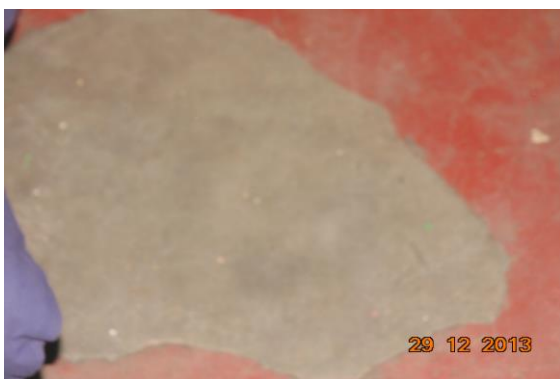
Photo 88

Dampness/Seepage on Roof of Varanda of House No. 2405 to 2408 of First Floor
