### Pre Building Condition Survey Report

Name and Address of Structure :	Badi Chopar to Ramp Area (UP Line)
---------------------------------	------------------------------------

Name of the Project	<b>Contract JMRC-UG1B</b> “Design and Construction of Tunnel between Chandpole and Badi Chouper and reverse line by Shield TBM, Underground Metro Stations at Choti Chouper and Badi Chouper by Cut and Cover Methods on East West Corridor of Jaipur Metro Rail Corporation Limited .”	
Owner :

Pre Building Condition Survey Report Badi Chopar to Ramp Area (UP Line)

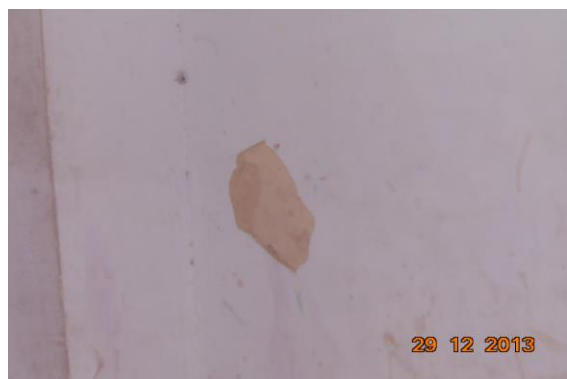
Photo 89

Peeling of Plaster on Floor of Toilet No. 8 of House No. 2405 to 2408, First Floor

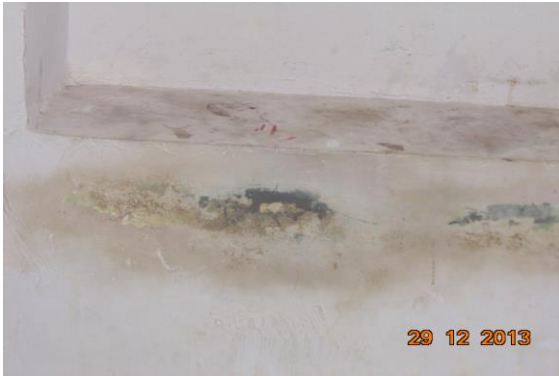
Photo 90

Peeling of Plaster on Wall No. 2 of Toilet No. 13 of House No. 2405 to 2408, First Floor

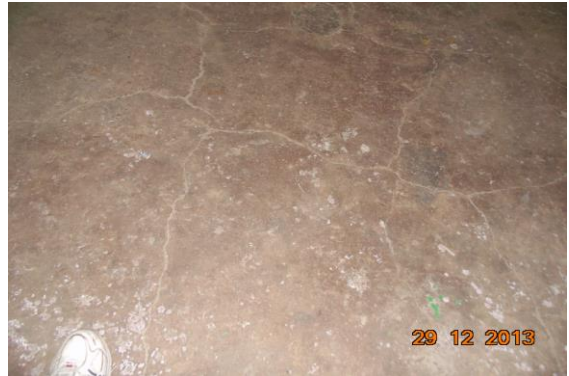
Photo 91

Dampness/Seepage on Wall No. 4 of Toilet No. 15 of House No. 2405 to 2408, First Floor

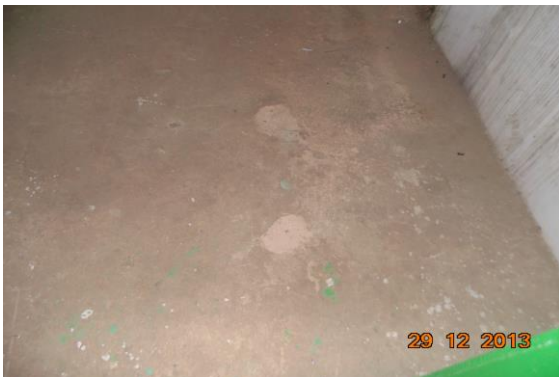
Photo 92

Plaster Crack on Floor of Hall No. 1 of House No. 2405 to 2408, First Floor

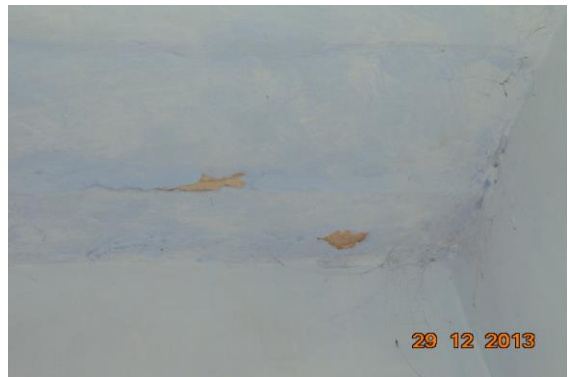
Photo 93

Peeling of Plaster on Floor of Toilet No. 27 of House No. 2405 to 2408, First Floor

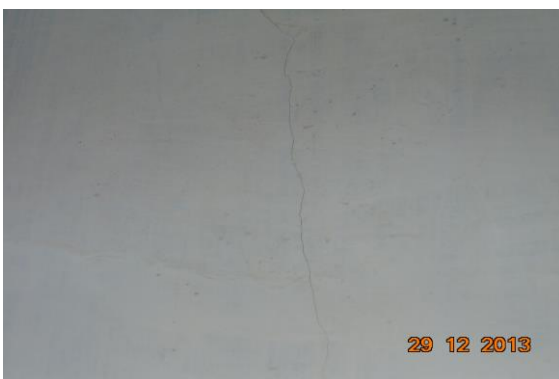
Photo 94

Peeling of Plaster on Roof of Toilet No. 19 of House No. 2405 to 2408, First Floor

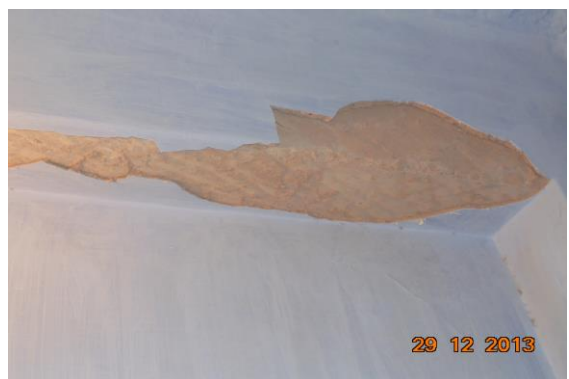
Photo 96

Peeling of Plaster on Wall No. 1 of Toilet No. 22 of House No. 2405 to 2408, First Floor

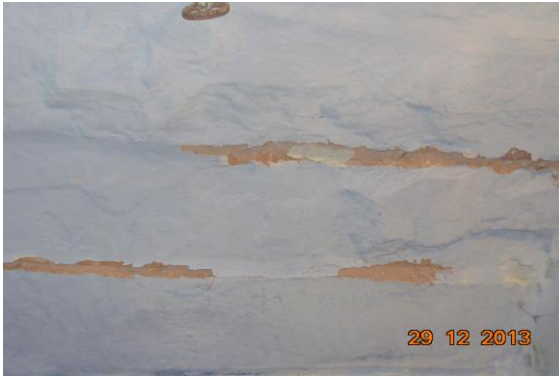
Photo 97

Peeling of Plaster on Roof of Toilet No. 22 of House No. 2405 to 2408, First Floor

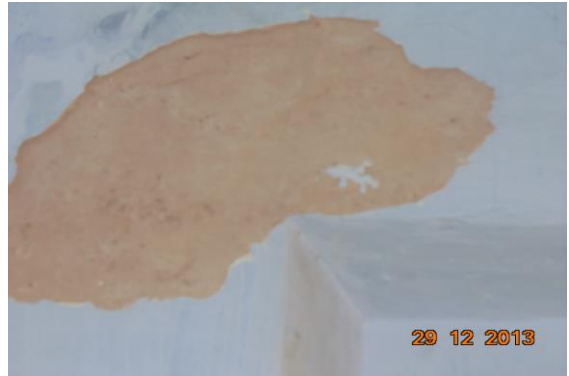
Photo 98

Peeling of Plaster on Wall No. 3 of Toilet No. 22 of House No. 2405 to 2408, First Floor

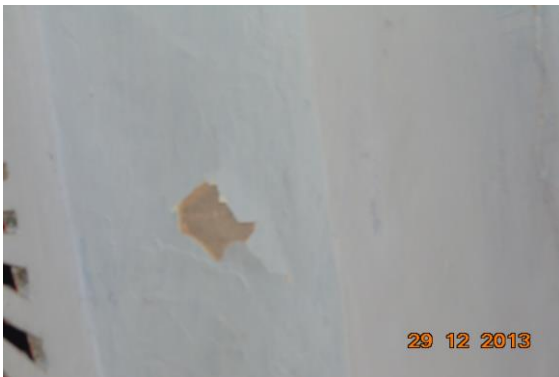
Photo 99

Peeling of Plaster on Wall No. 2 of Toilet No. 22 of House No. 2405 to 2408, First Floor

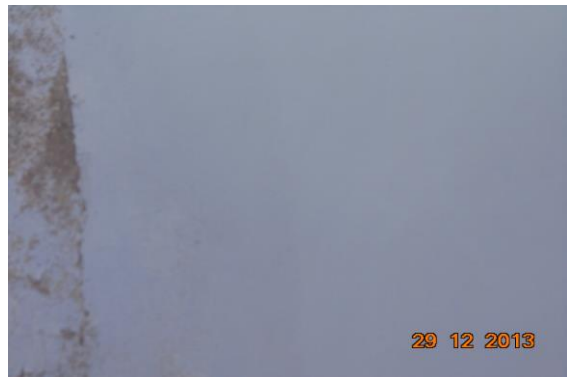
Photo 100

Dampness/Seepage on Roof of Hall No. 3 of House No. 2405 to 2408, First Floor

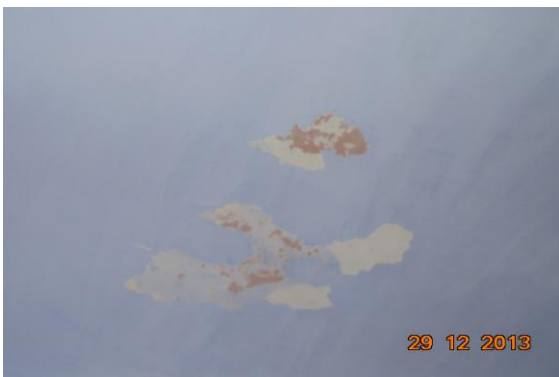
Photo 101

Dampness/Seepage on Roof of Hall No. 3 of House No. 2405 to 2408, First Floor

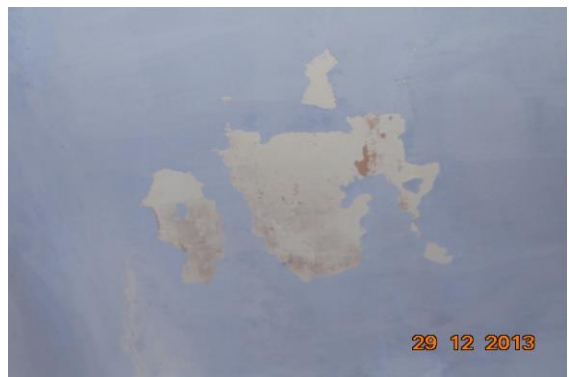
Photo 102

Dampness/Seepage on Roof of Hall No. 3 of House No. 2405 to 2408, First Floor

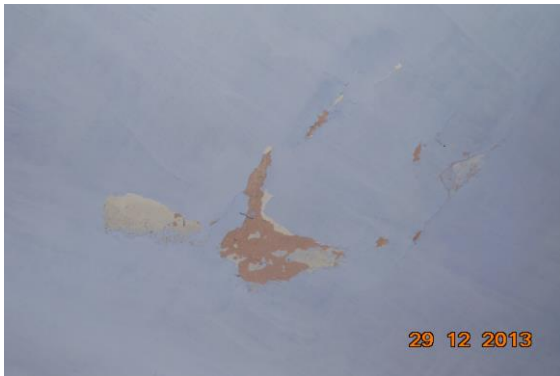
Photo 103

Dampness/Seepage on Roof of Hall No. 3 of House No. 2405 to 2408, First Floor

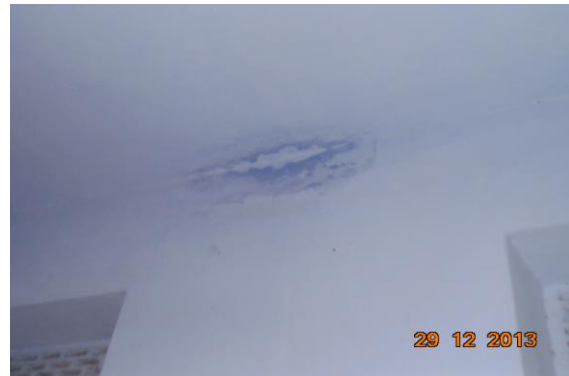
Photo 104

Dampness/Seepage on Wall No. 3 of Hall No. 3 of House No. 2405 to 2408, First Floor

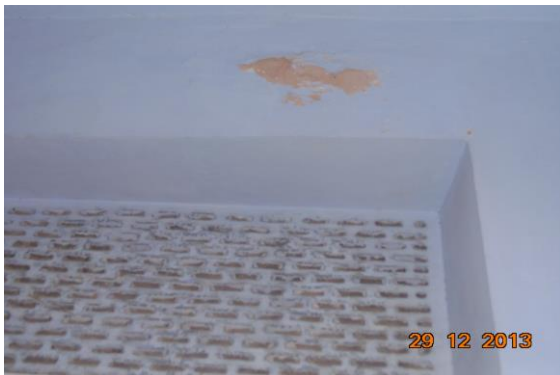
Photo 105

Dampness/Seepage on Wall No. 3 of Hall No. 3 of House No. 2405 to 2408, First Floor

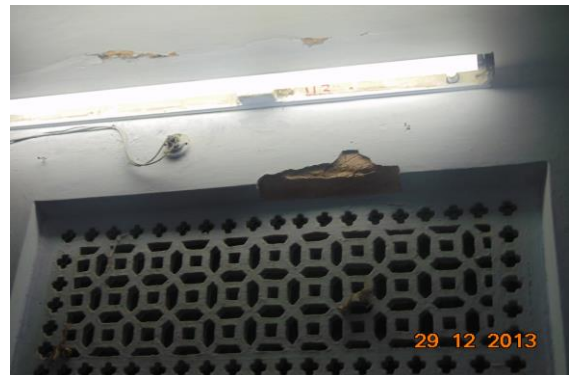
Photo 106

Peeling of Plaster on Wall No. 2 of Hall No. 3 of House No. 2405 to 2408, First Floor

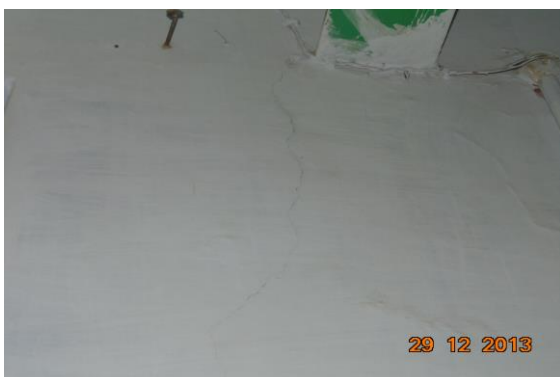
Photo 107

Plaster Crack on Wall No. 2 of Hall No. 3 of House No. 2405 to 2408, First Floor

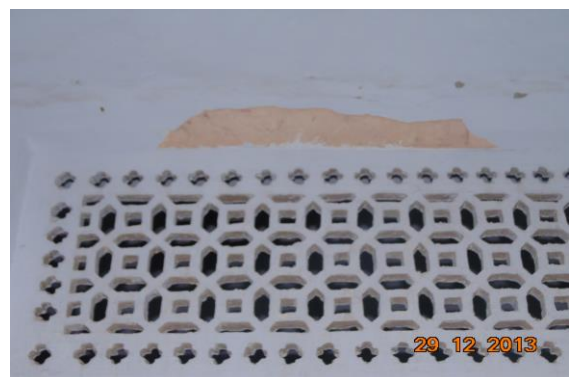
Photo 108

Peeling of Plaster on Wall No. 1 of Hall No. 3 of House No. 2405 to 2408, First Floor

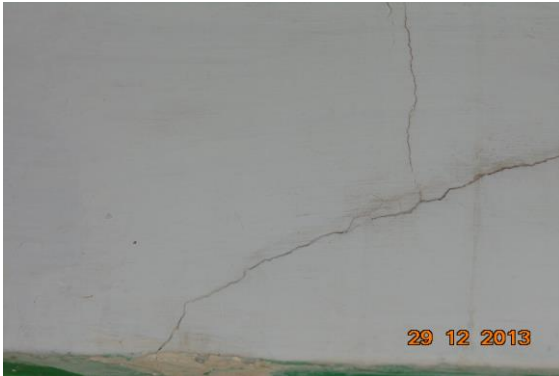
Photo 109

Plaster Crack on Wall No. 2 of Hall No. 3 of House No. 2405 to 2408, First Floor

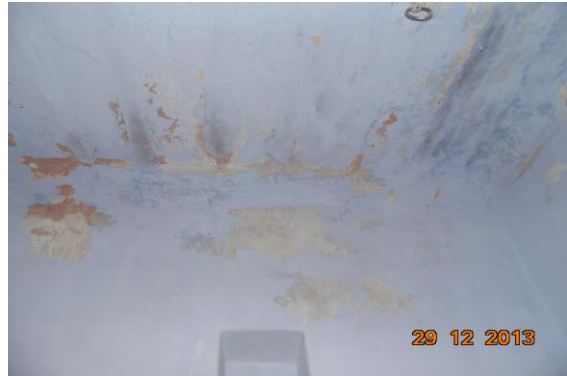
Photo 110

Dampness/Seepage on Roof & Wall No. 2 & 4 of Toilet No. 23 of House No. 2405 to 2408, First Floor

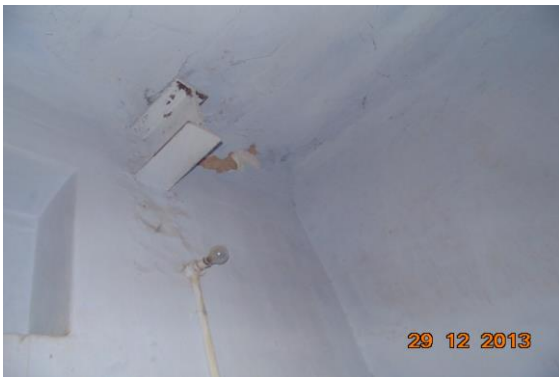
Photo 111

Peeling of Plaster on Wall No. 3 of Toilet No. 23 of House No. 2405 to 2408, First Floor

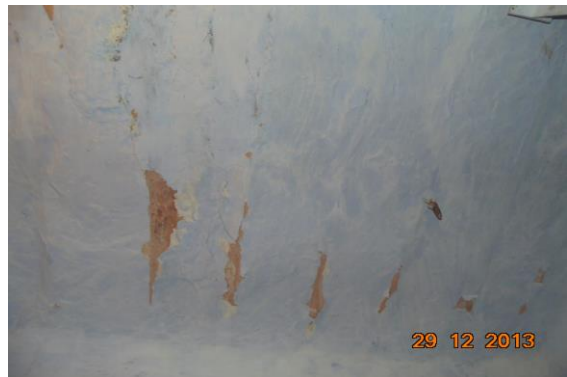
Photo 112

Peeling of Plaster on Roof of Toilet No. 24 of House No. 2405 to 2408, First Floor

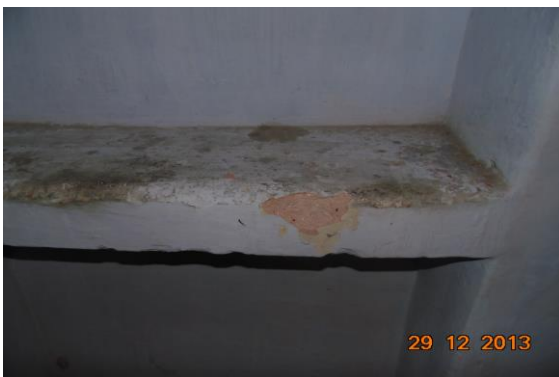
Photo 113

Peeling of Plaster on Wall No. 2 of Toilet No. 24 of House No. 2405 to 2408, First Floor

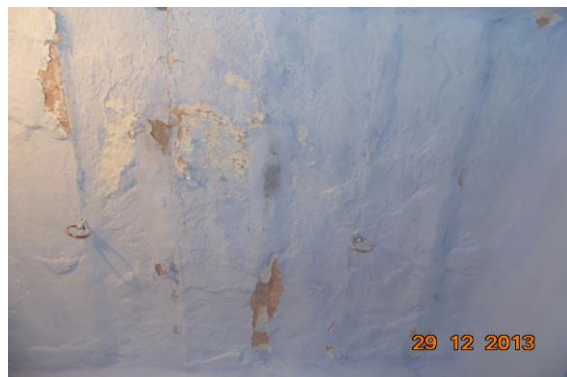
Photo 114

Dampness/Seepage on Roof of Toilet No. 25 of House No. 2405 to 2408, First Floor

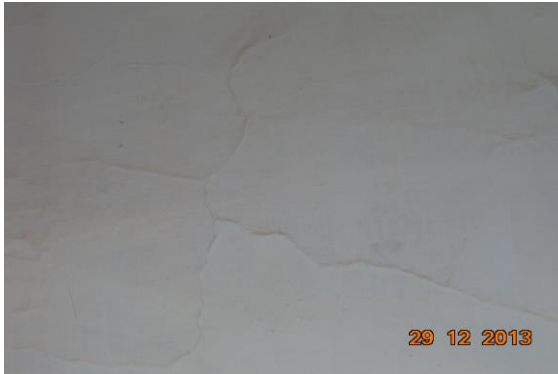
Photo 115

Plaster Crack on Wall No. 4 of Toilet No. 25 of House No. 2405 to 2408, First Floor

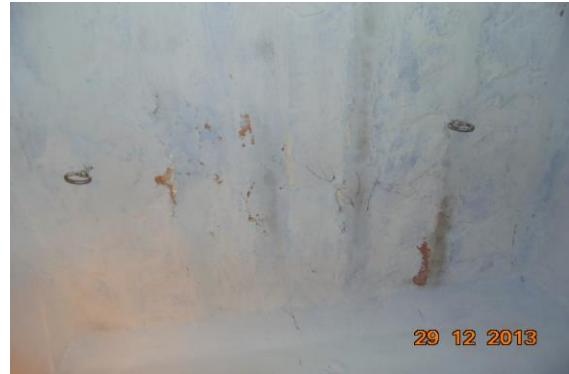
Photo 116

Dampness/Seepage on Roof of Toilet No. 26 of House No. 2405 to 2408, First Floor

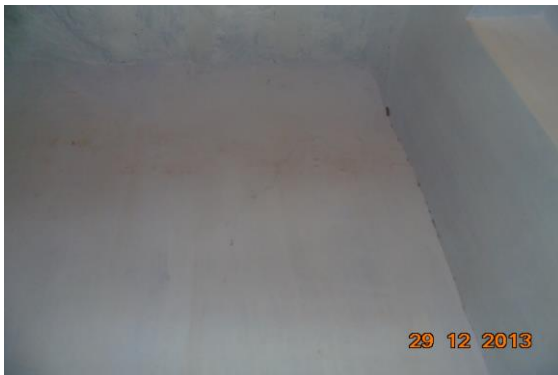
Photo 117

Plaster Crack on Wall No. 4 of Toilet No. 26 of House No. 2405 to 2408, First Floor

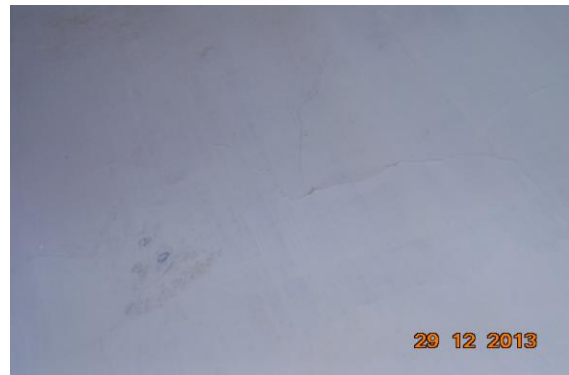
Photo 118

Plaster Crack on Wall No. 4 of Toilet No. 26 of House No. 2405 to 2408, First Floor

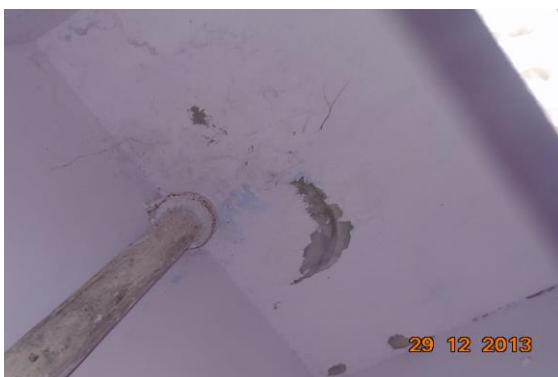
Photo 119

Dampness/Seepage on Roof of Bathroom No. of House No. 2405 to 2408, First Floor

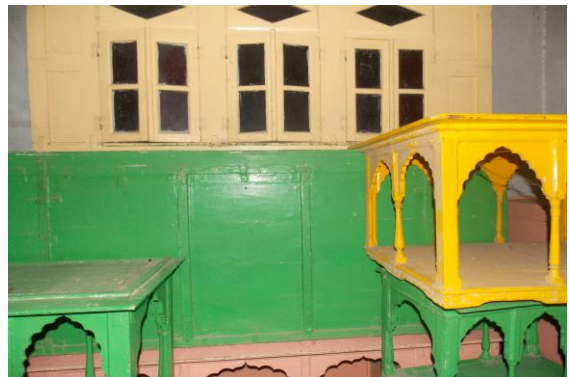
Photo 135

Room No. 26 of House No. 2405 to 2408, Ground Floor Locked

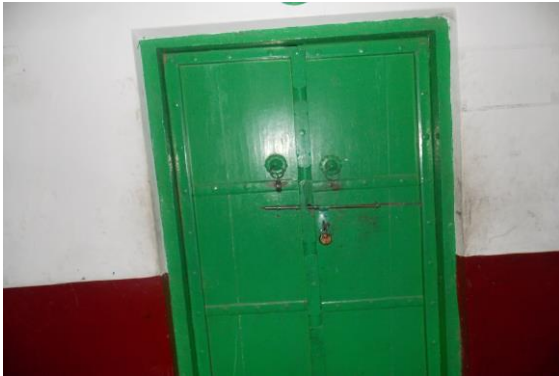
Photo 138

Room No. 23 of House No. 2405 to 2408, Ground Floor Locked

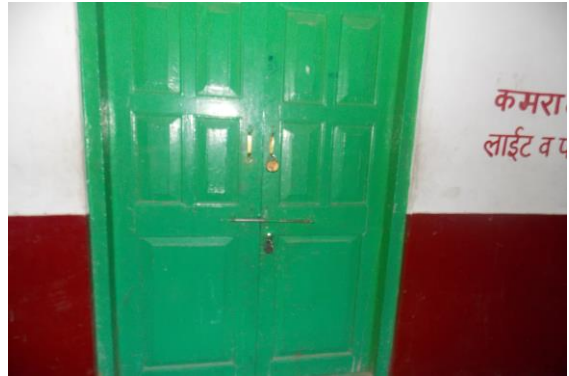
Photo 139

Room No. 22 of House No. 2405 to 2408, Ground Floor Locked

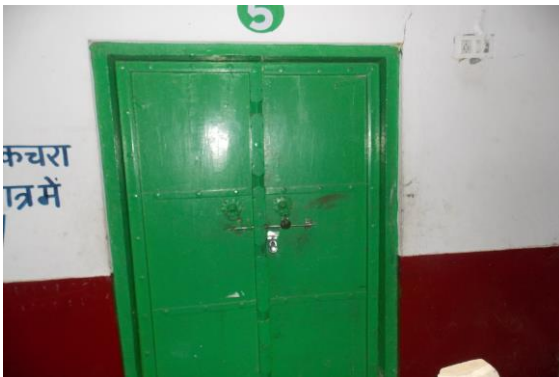
Photo 140

Room No. 17 of House No. 2405 to 2408, Ground Floor Locked

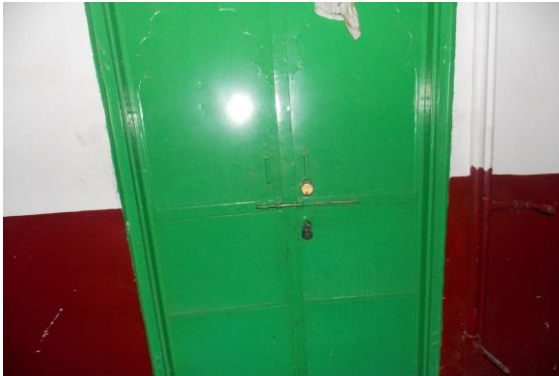
Photo 144

Room No. 6 of House No. 2405 to 2408, Second Floor Locked

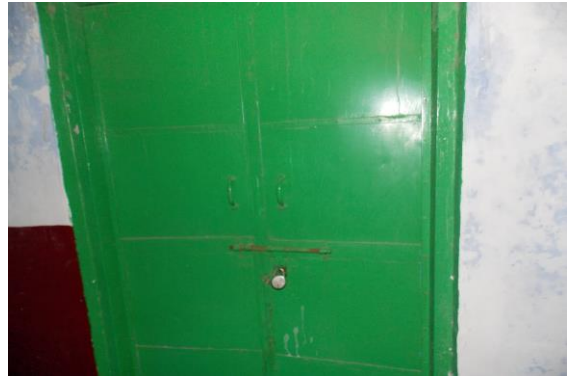
Photo 145

Room No. 5 of House No. 2405 to 2408, Second Floor Locked

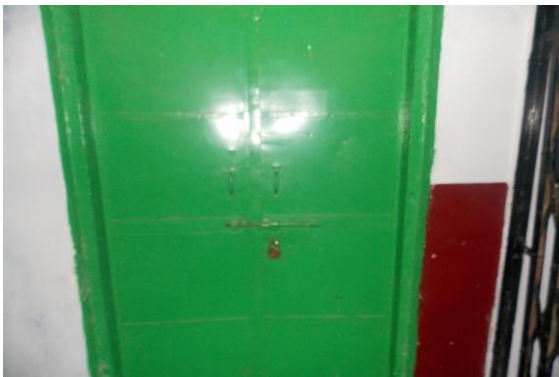
Photo 146

Room No. 4 of House No. 2405 to 2408, Second Floor Locked

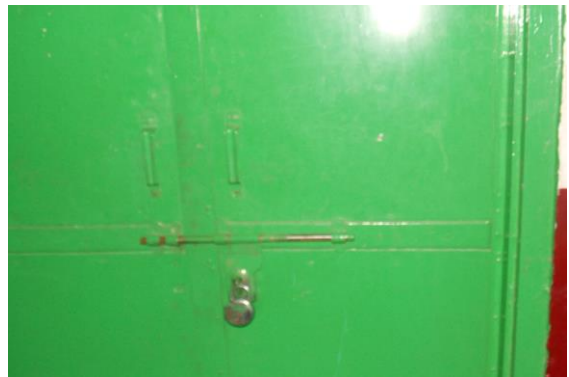
Photo 147

Room No. 3 of House No. 2405 to 2408, Second Floor Locked

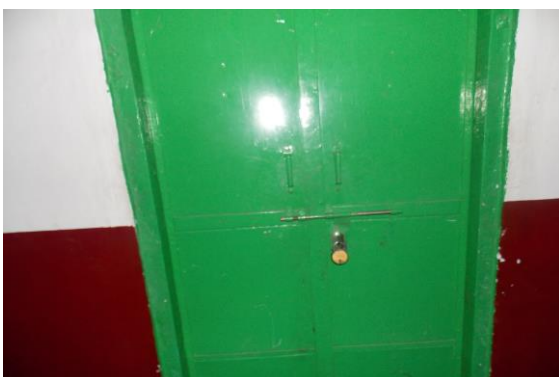
Photo 148

Room No. 22 of House No. 2405 to 2408, Second Floor Locked

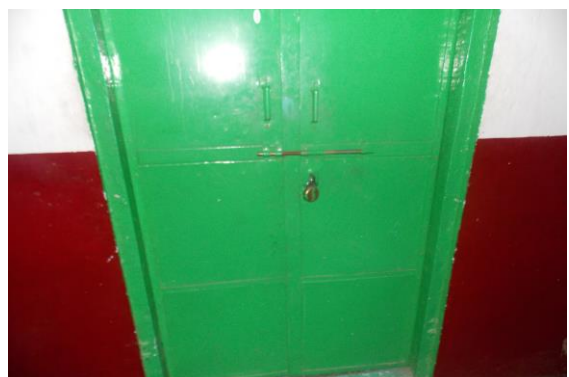
Photo 149

Room No. 20 of House No. 2405 to 2408, Second Floor Locked

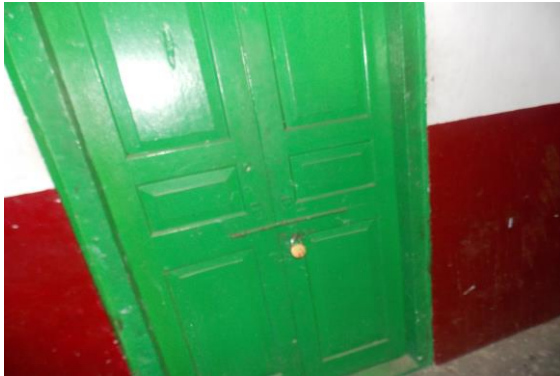
Photo 150

Room No. 19 of House No. 2405 to 2408, Second Floor Locked

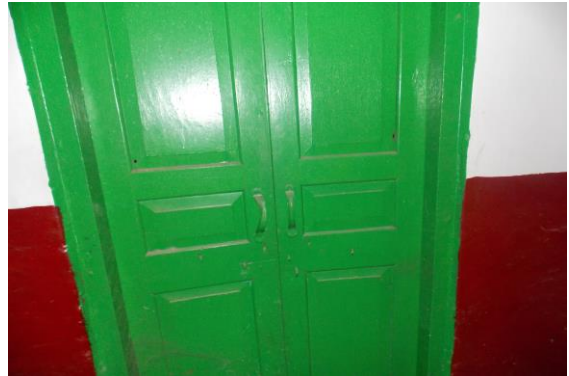
Photo 151

Room No. 16 of House No. 2405 to 2408, Second Floor Locked

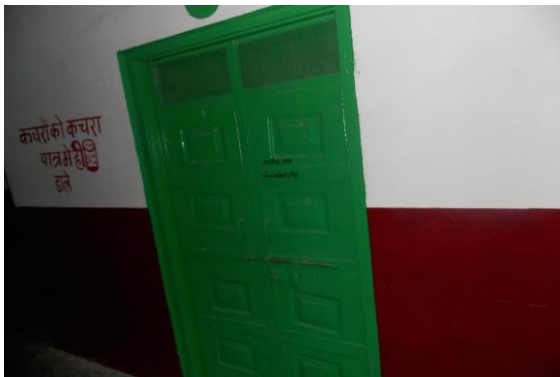
Photo 152

Room No. 15 of House No. 2405 to 2408, Second Floor Locked

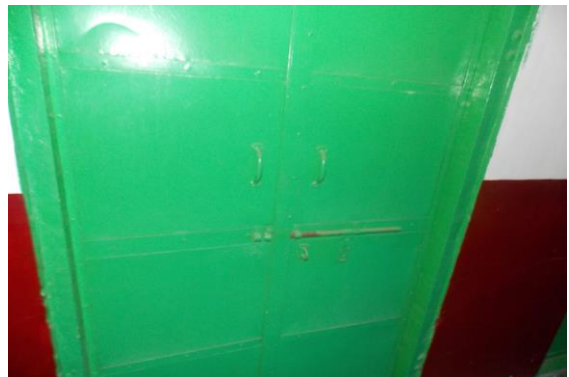
Photo 153

Room No. 14 of House No. 2405 to 2408, Second Floor Locked

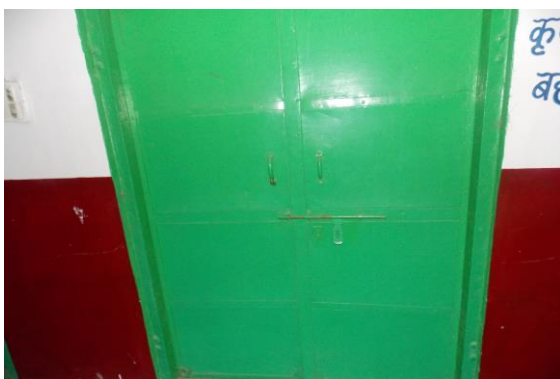
Photo 154

Room No. 13 of House No. 2405 to 2408, Second Floor Locked

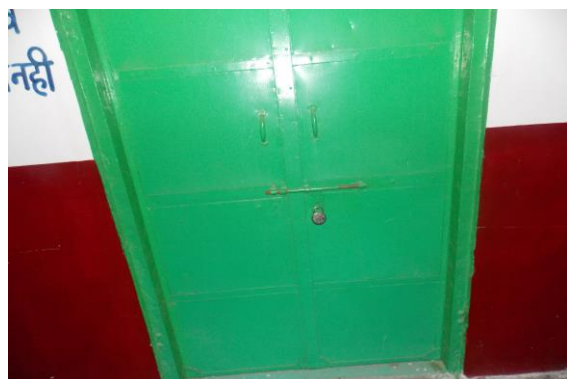
Photo 155

Hall No. 1 of House No. 2405 to 2408, Second Floor Locked

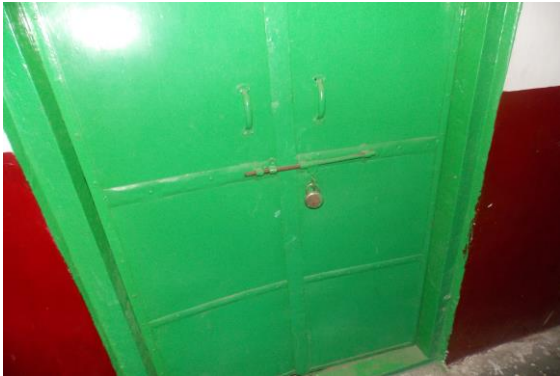
Photo 156

Room No. 11 of House No. 2405 to 2408, Second Floor Locked

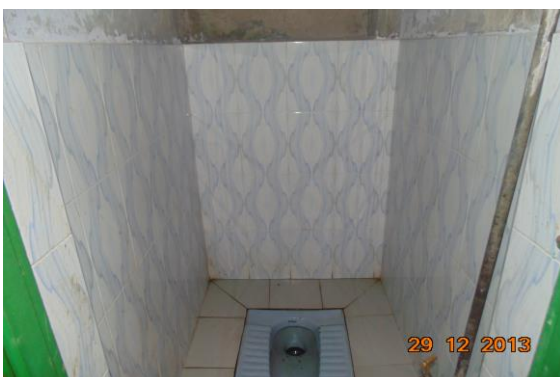
Photo 160

All wall of Toilet No. 2 of House No. 2405 to 2408, First Floor 1/2 Portion Covered with Tiles

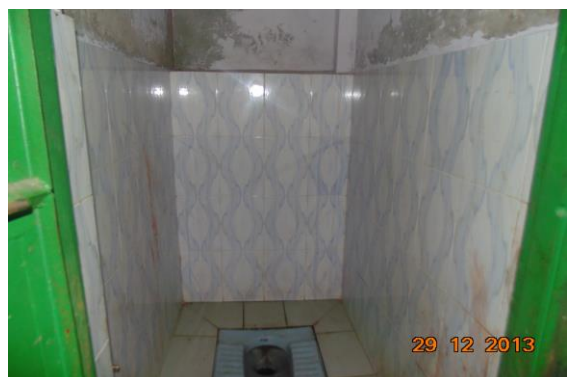
Photo 161

All wall of Toilet No. 3 of House No. 2405 to 2408, First Floor Covered with Tiles, 1/2 Portion

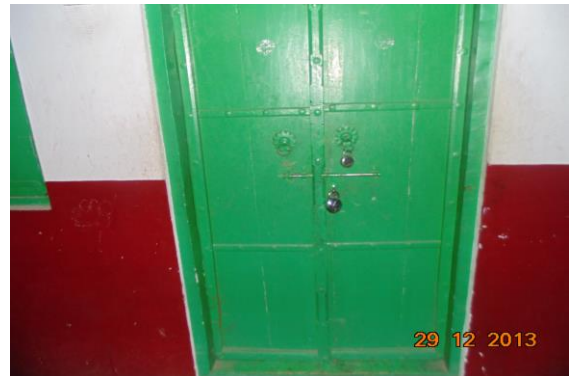
Photo 163

Toilet No. 7 of House No. 2405 to 2408, First Floor Locked

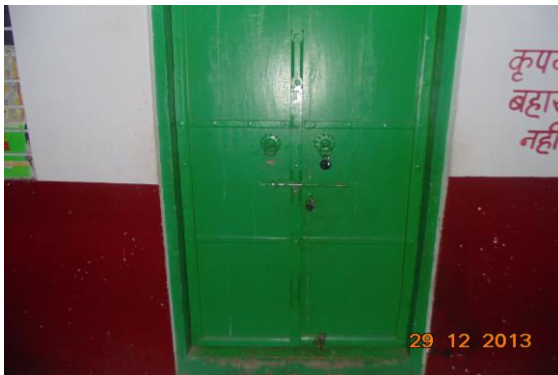
Photo 164

Toilet No. 9 of House No. 2405 to 2408, First Floor Locked

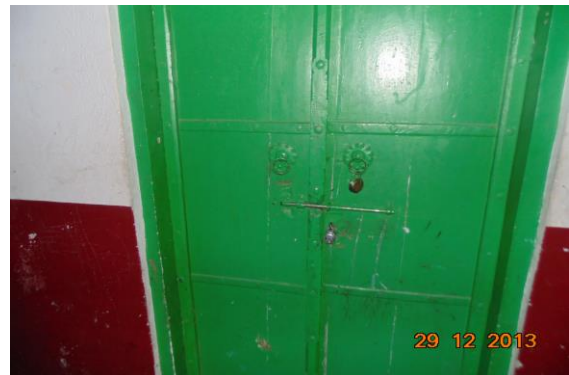
Photo 165

Toilet No. 10 of House No. 2405 to 2408, First Floor Locked

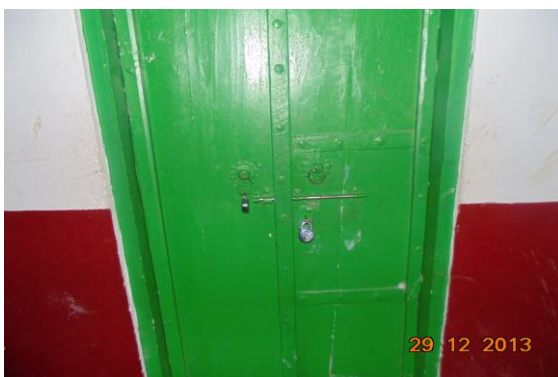
Photo 166

Toilet No. 14 of House No. 2405 to 2408, First Floor Locked

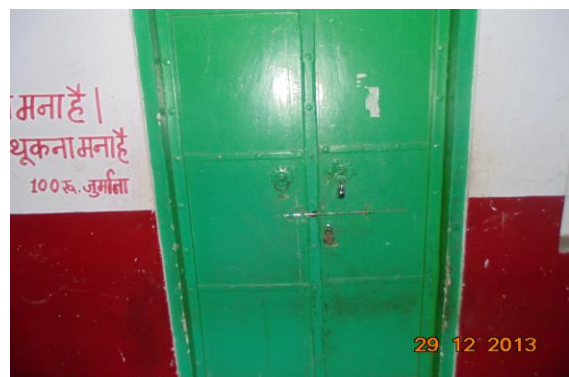
Photo 167

Toilet No. 16 of House No. 2405 to 2408, First Floor Locked

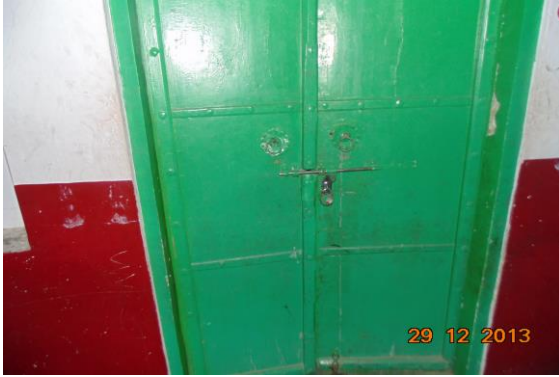
Photo 168

Toilet No. 17 of House No. 2405 to 2408, First Floor Locked

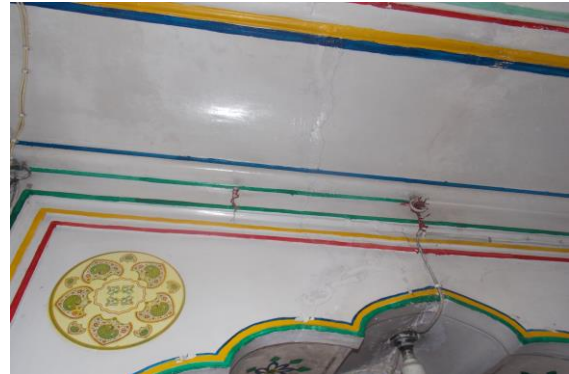
Photo 4  
Inclined Crack on Wall No. 3 & Roof of Varanda 2, Part A, House No. 2414, First Floor Approx. Width = 0.3mm, Approx. Length = 1.8m. Distance from Wall No.1 = 1.5m, Height from Floor = 2.4m.

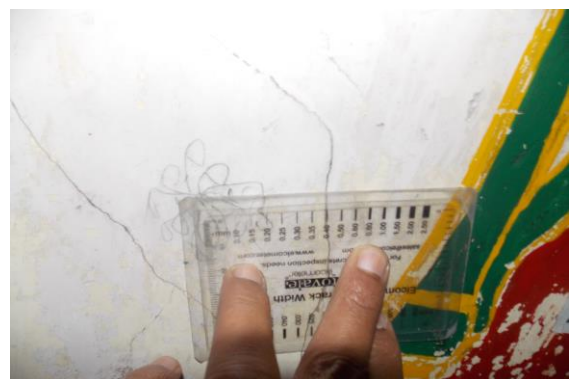
Photo 5A  
Inclined Crack on Wall No. 5 of Varanda 2, Part A, House No. 2414, First Floor Approx. Width = 0.4mm, Approx. Length = 1.2m. Distance from Wall No.1 = 1.3m, Height from Floor = 0m.

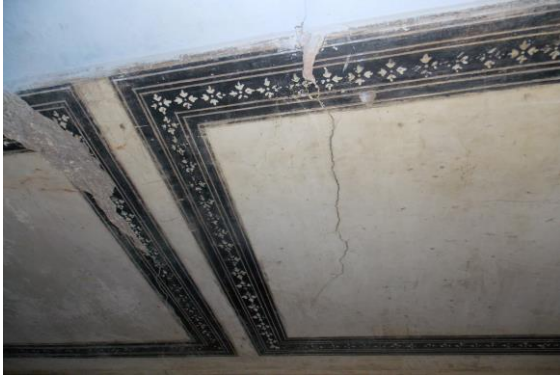
Photo 6

Inclined Crack on Wall No. 7 of Varanda 2, Part A, House No. 2414, First Floor Approx. Width = 1.5mm, Approx. Length = 1.2m. Distance from Wall No.1 = 3m, Height from Floor = 0m.

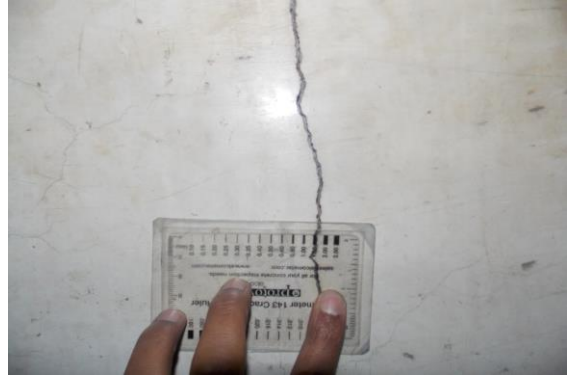
Photo 6A

Inclined Crack on Wall No. 7 of Varanda 2, Part A, House No. 2414, First Floor Approx. Width = 1.5mm, Approx. Length = 1.2m. Distance from Wall No.1 = 3m, Height from Floor = 0m.

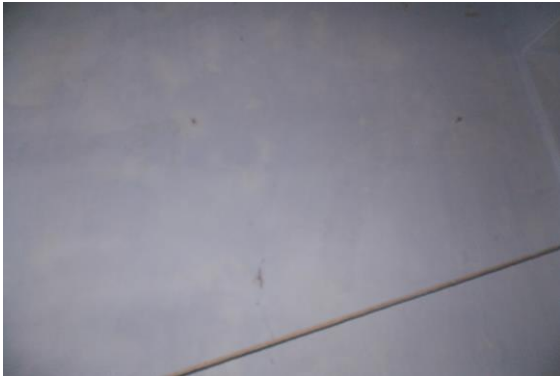
Photo 7

Inclined Crack on Wall No. 2 of Varanda 2, Part A, House No. 2414, First Floor Approx. Width = 0.8mm, Approx. Length = 3.3m. Distance from Wall No.4 = 3m, Height from Floor = 0m.

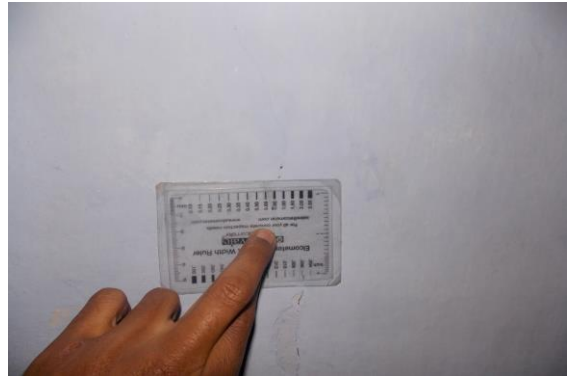
Photo 7A

Inclined Crack on Wall No. 2 of Varanda 2, Part A, House No. 2414, First Floor Approx. Width = 0.8mm, Approx. Length = 3.3m. Distance from Wall No.4 = 3m, Height from Floor = 0m.

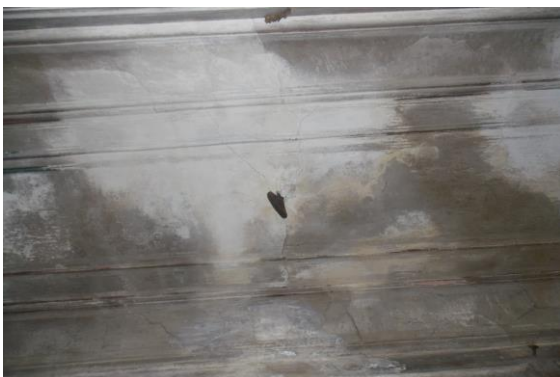
Photo 8

Inclined Crack on Roof of Varanda 2, Part A, House No. 2414, First Floor Approx. Width = 1mm, Approx. Length = 2.5m. Distance from Wall No.2 = 1m, Height from Floor = 3m.

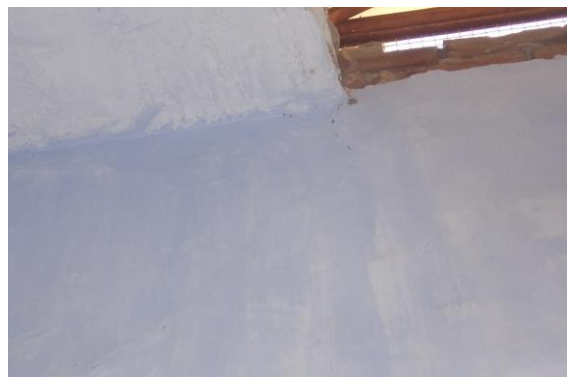
Photo 9

Inclined Crack on Wall No. 3 of Sky Open 2, Part A, House No. 2414, First Floor Approx. Width = 1mm, Approx. Length = 1.3m. Distance from Wall No.2 = 0.5m, Height from Floor = 3m.

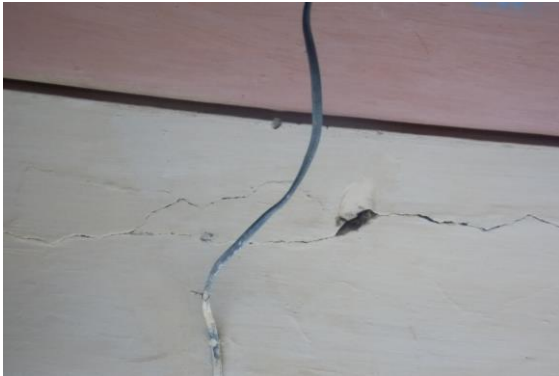
Photo 10

Inclined Crack on Wall No. 1,4 & Roof of Room No. 1, House No. 2414, Ground Floor Approx. Width = 2.5mm, Approx. Length = 6.5m. Distance from Wall No.4 = 0m, Height from Floor = 2.5m.

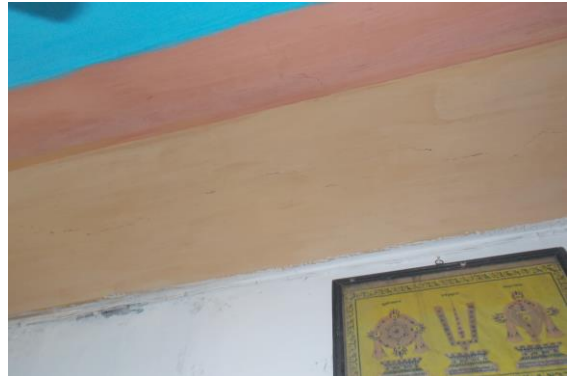
Photo 11

Inclined Crack on Wall No. 1,4 & Roof of Room No. 1, House No. 2414, Ground Floor Approx. Width = 2.5mm, Approx. Length = 6.5m. Distance from Wall No.4 = 0m, Height from Floor = 2.5m.

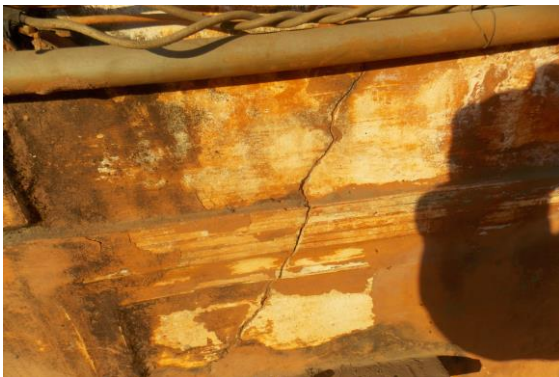
Photo 12

Inclined Crack on Wall No. 4 of Varanda 3 of Part A, House No. 2414, Ground Floor  
Approx. Width = 2mm, Approx. Length = 1.5m.  
Distance from Wall No 1 = 4m Height from Floor = 0m

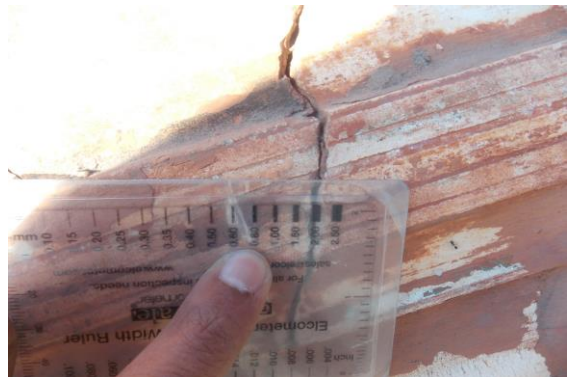
Photo 12A

Inclined Crack on Wall No. 4 of Varanda 3 of Part A, House No. 2414, Ground Floor Approx. Width = 2mm, Approx. Length = 1.5m. Distance from Wall No.1 = 4m, Height from Floor = 0m.

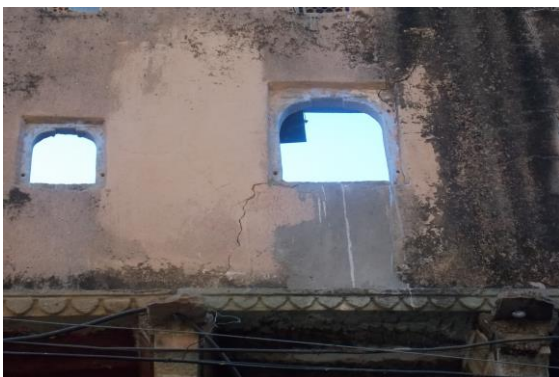
Photo 13

Inclined Crack on Wall No. 2 of House No. 2414, First Floor Approx. Width = 2mm, Approx. Length = 2.5m. Distance from Wall No.3 = 5.5m, Height from Floor = 4m.

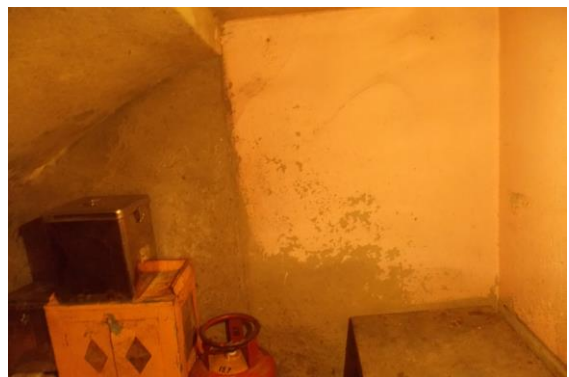
Photo 14

Peeling of Plaster on Wall No. 4 of Shop No.284 of Ground Floor

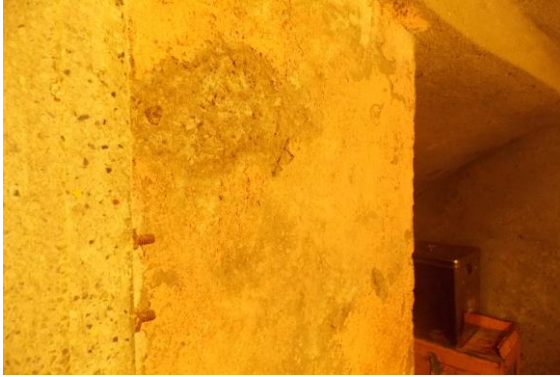
Photo 15  
Peeling of Plaster on Wall No. 1 of Shop No.284 of Ground Floor

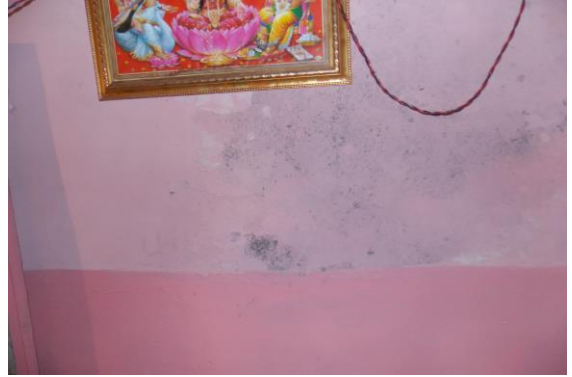
Photo 16  
Peeling of Plaster on Wall No. 4 of Shop No.284 of Ground Floor

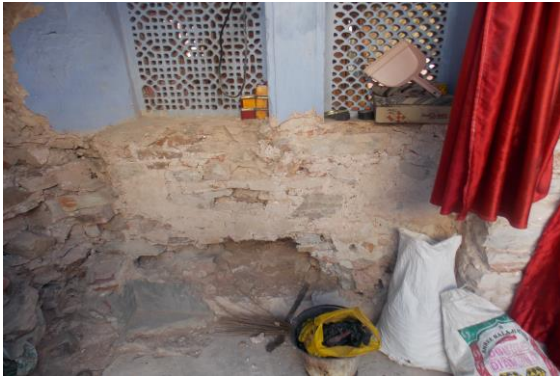
Photo 17  
Peeling of Plaster on Open Sky Wall 3, Part A of House No. 2414, First Floor

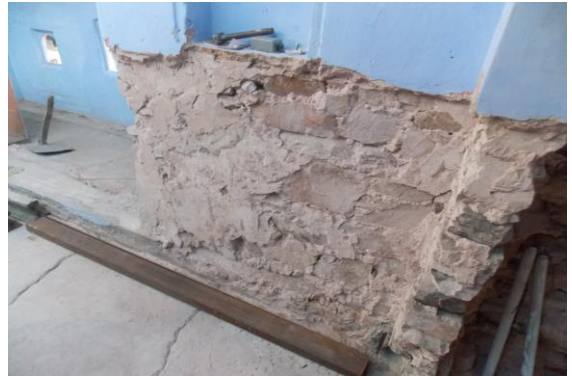
Photo 18  
Damaged Portion on Wall No. 2 of Open Sky Wall 3, Part A of House No. 2414, First Floor

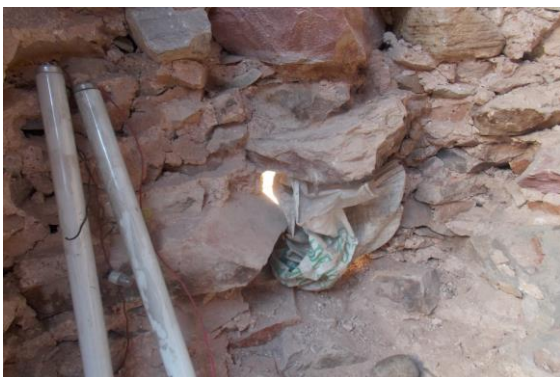
Photo 19  
Damaged Portion on Wall No. 2 of Open Sky Wall 3, Part A of House No. 2414, First Floor

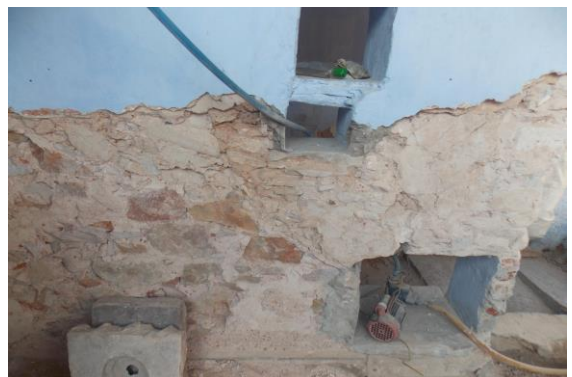
Photo 20  
Damaged Portion on Wall No. 4 of Open Sky Wall 3, Part A of House No. 2414, First Floor

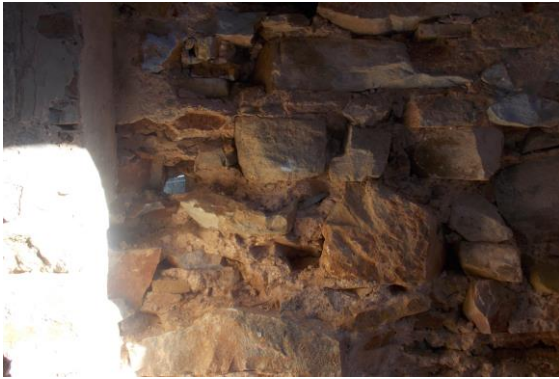
Photo 21

Damaged Portion on Wall No. 2 of Open Sky Wall 3, Part A of House No. 2414, First Floor

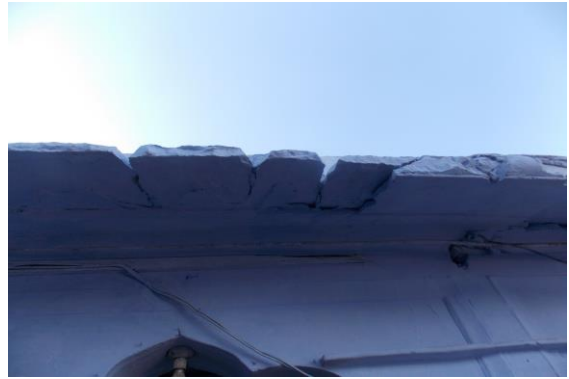
Photo 22

Damaged Portion on Sunshade of Open Sky Wall 3, Part A of House No. 2414, First Floor

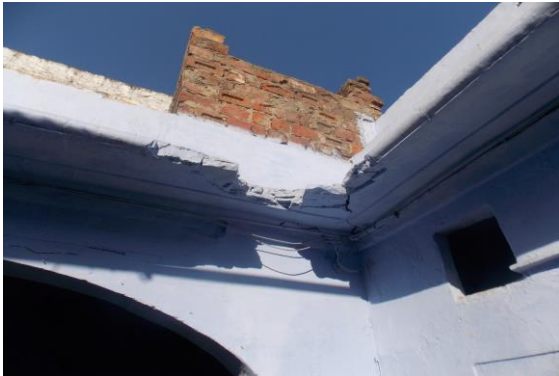
Photo 23

Damaged Portion on Sunshade of Open Sky Wall 3, Part A of House No. 2414, First Floor

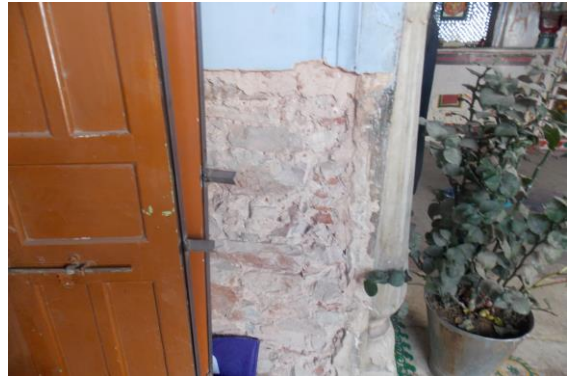
Photo 24

Damaged Portion on Wall No. 4 of Varanda 1, Part A of House No. 2414, First Floor

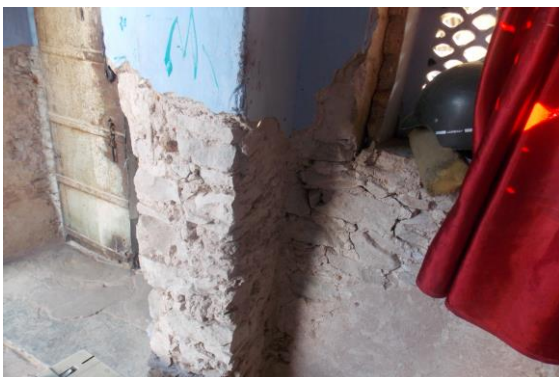
Photo 25

Damaged Portion on Wall No. 1 & 3 of Varanda 1, Part A of House No. 2414, First Floor

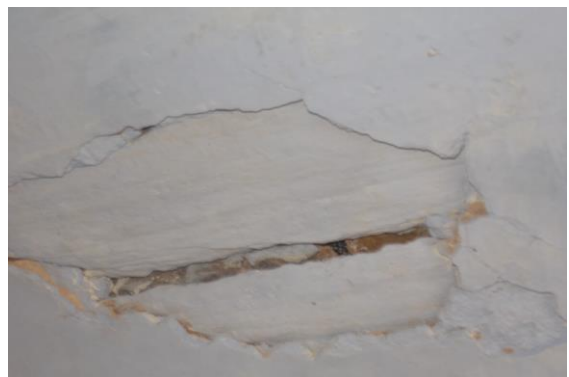
Photo 26

Damaged Portion on Roof of Varanda 1, Part A of House No. 2414, First Floor

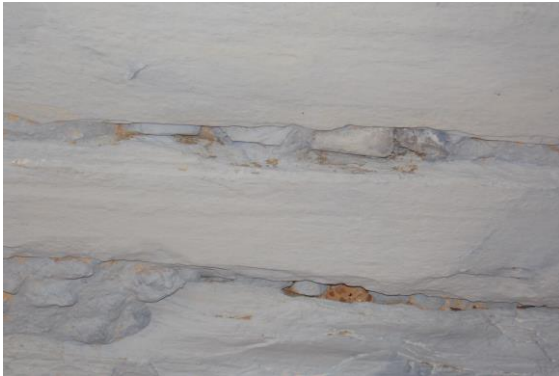
Photo 27

Damaged Portion on Roof of Varanda 1, Part A of House No. 2414, First Floor

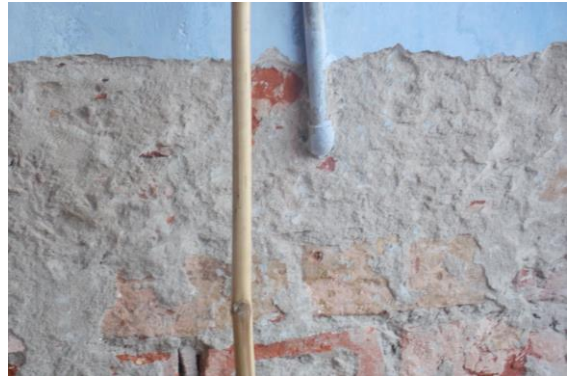
Photo 28

Peeling of Plaster on Wall No. 2 of Varanda 1, Part A of House No. 2414, First Floor

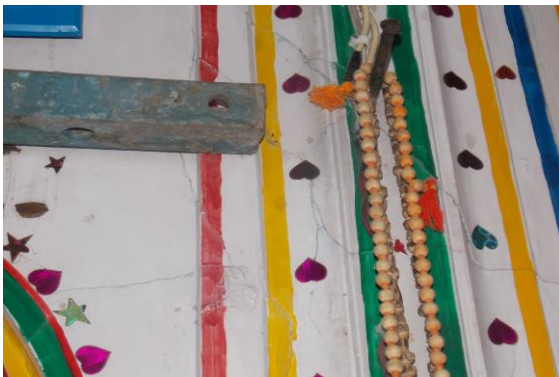
Photo 29

Plaster Crack on Wall No. 5 of Varanda 2, Part A of House No. 2414, First Floor

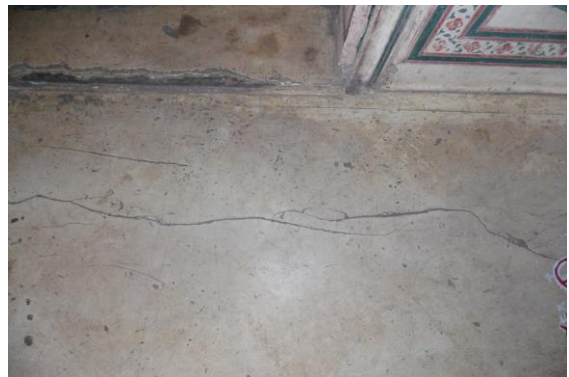
Photo 30

Plaster Crack on Floor of Varanda 2, Part A of House No. 2414, First Floor

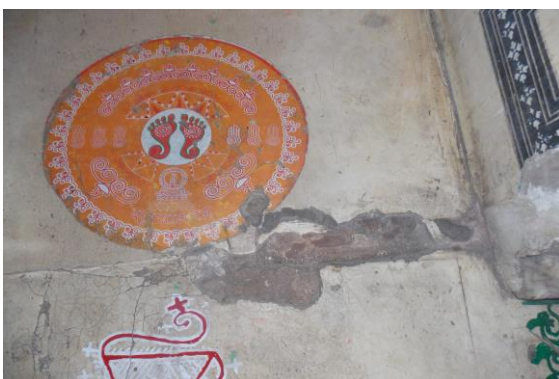
Photo 31

Peeling of Plaster on Floor of Varanda 2, Part A of House No. 2414, First Floor

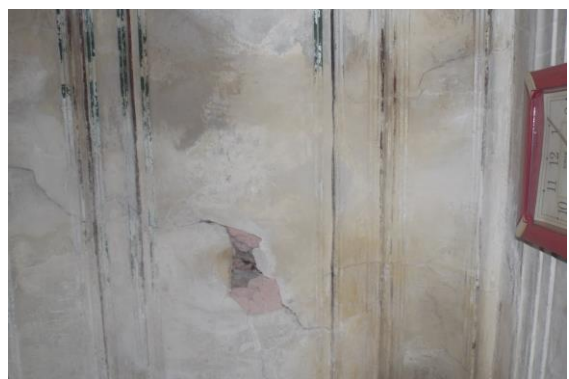
Photo 32

Peeling of Plaster on Roof of Varanda 2, Part A of House No. 2414, First Floor

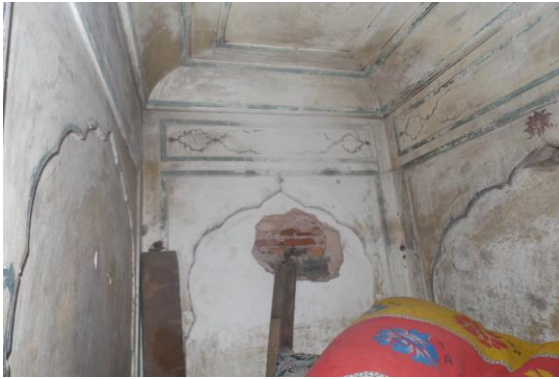
Photo 33

Peeling of Plaster on Wall No. 1 of Store Room 1, Part A of House No. 2414, First Floor

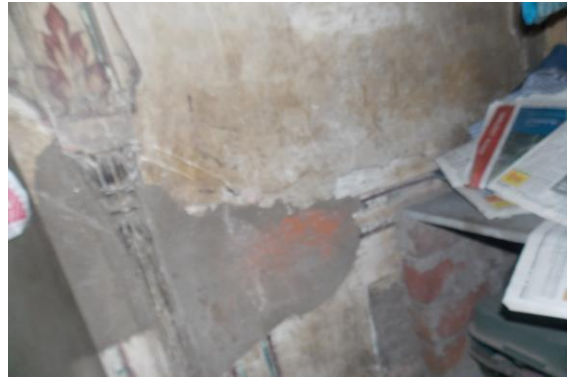
Photo 34

Peeling of Plaster on Wall No. 4 of Store Room 1, Part A of House No. 2414, First Floor

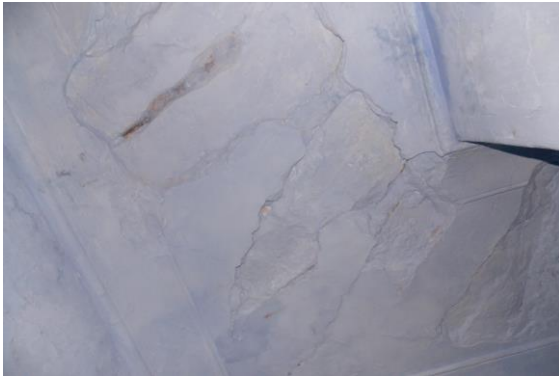
Photo 35

Peeling of Plaster on Roof of Varanda 2, Part A of House No. 2414, First Floor

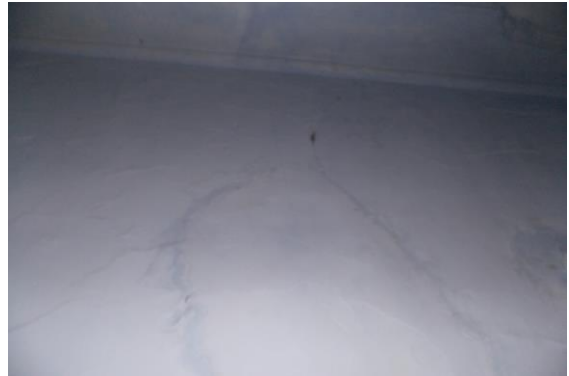
Photo 36

Peeling of Plaster on Wall No. 4 of Varanda 2, Part A of House No. 2414, First Floor

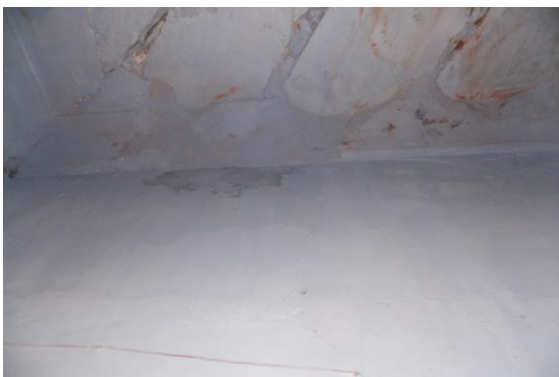
Photo 37

Peeling of Plaster on Roof of Varanda 2, Part A of House No. 2414, First Floor

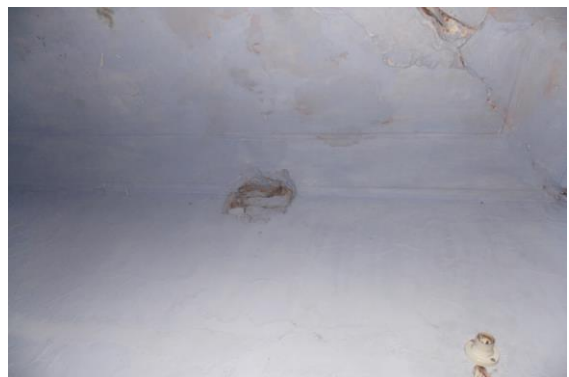
Photo 38

Peeling of Plaster on Wall No. 4 of Varanda 2, Part A of House No. 2414, First Floor

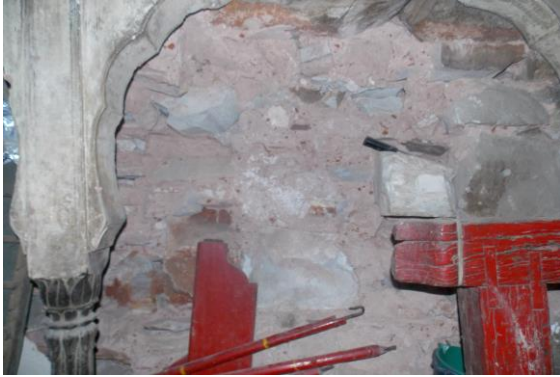
Photo 39

Peeling of Plaster on Wall No. 4 of Store Room 2, Part A of House No. 2414, First Floor

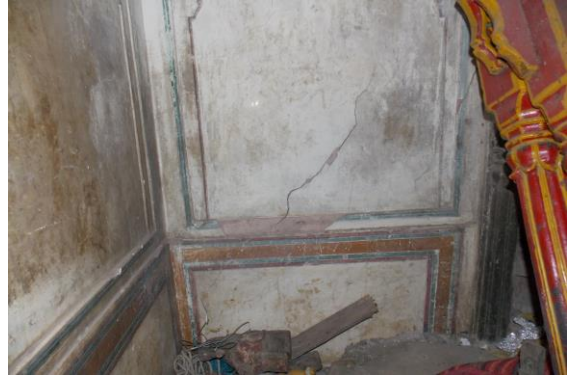
Photo 40

Peeling of Plaster on Wall No. 1 of Store Room 2, Part A of House No. 2414, First Floor
