### Pre Building Condition Survey Report

Name and Address of Structure :	Badi Chopar to Ramp Area (UP Line)
---------------------------------	------------------------------------

Name of the Project	<b>Contract JMRC-UG1B</b> “Design and Construction of Tunnel between Chandpole and Badi Chouper and reverse line by Shield TBM, Underground Metro Stations at Choti Chouper and Badi Chouper by Cut and Cover Methods on East West Corridor of Jaipur Metro Rail Corporation Limited .”	
Owner :

Pre Building Condition Survey Report Badi Chopar to Ramp Area (UP Line)

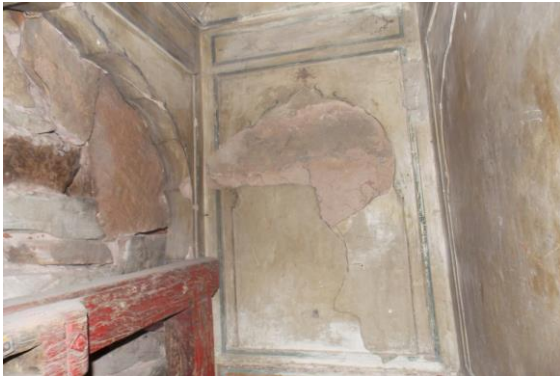
Photo 41

Peeling of Plaster on Wall No. 2 of Store Room 2, Part A of House No. 2414, First Floor

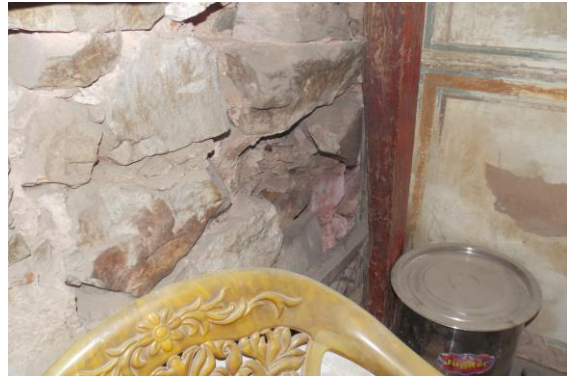
Photo 42

Damaged Portion on Wall No. 4 of Store Room 2, Part A of House No. 2414, First Floor

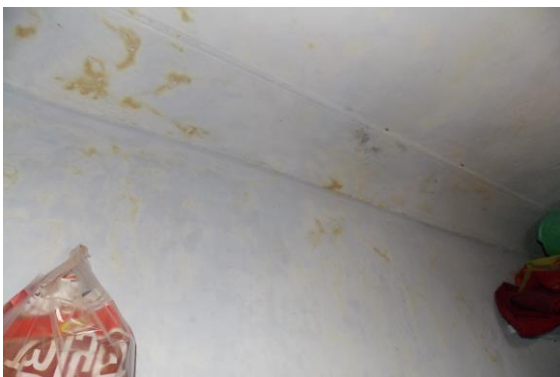
Photo 43

Dampness/Seepage on Wall No. 4 of Room No. 1 of House No. 2414, First Floor

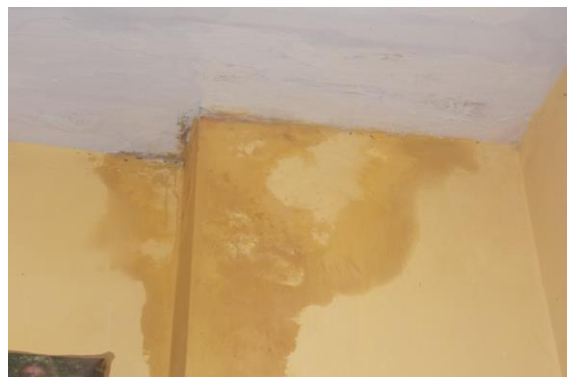
Photo 44

Dampness/Seepage on Wall No. 1 of Room No. 2 of House No. 2414, First Floor

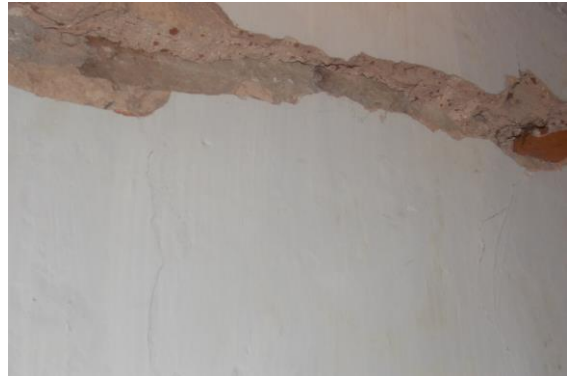
Photo 46

Peeling of Plaster on Wall No. 1 of Store Room 3, Part A of House No. 2414, First Floor

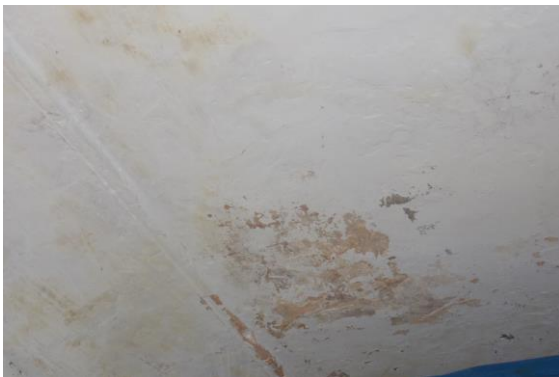
Photo 47

Peeling of Plaster on Roof of Store Room 3, Part A of House No. 2414, First Floor

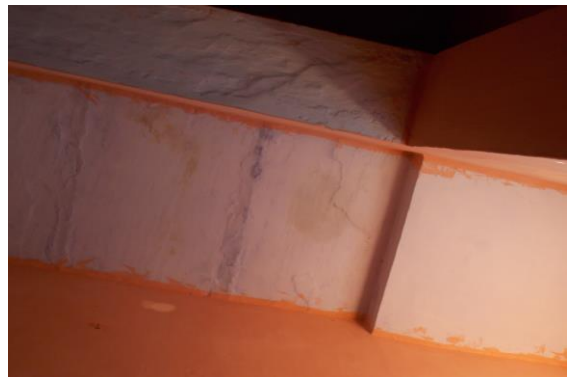
Photo 48

Dampness/Seepage on Roof of Room No. 3 of House No. 2414, First Floor

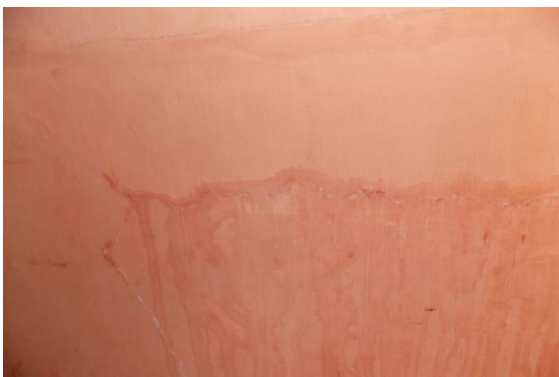
Photo 49

Dampness/Seepage on Wall No. 2 of Room No. 3 of House No. 2414, First Floor

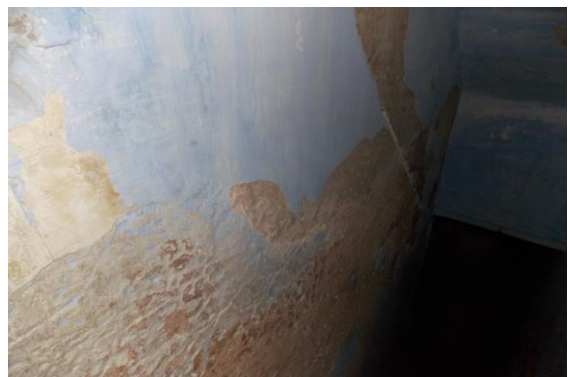
Photo 50

Peeling of Plaster on Wall No. 1 of Stair Ground Floor to First Floor, Part A of House No. 2414, Ground Floor

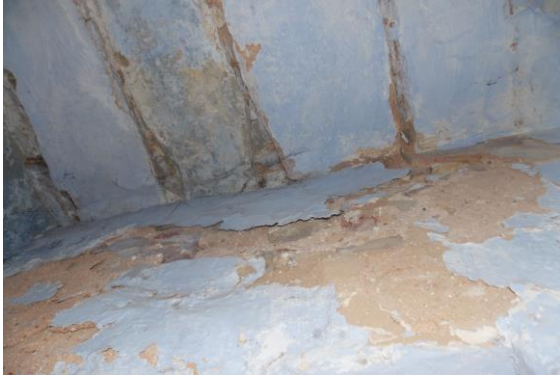
Photo 51

Peeling of Plaster on Wall No. 1 of Stair Ground Floor to First Floor,  
Part A of House No. 2414, Ground Floor

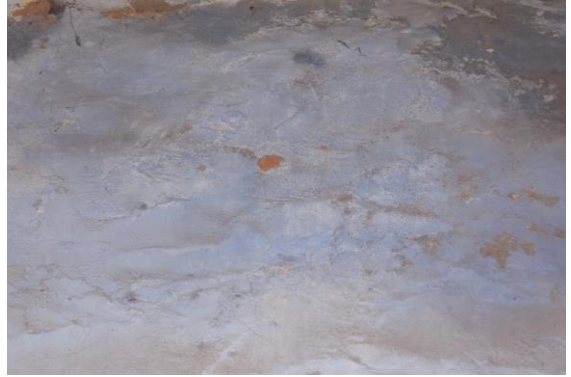
Photo 52

Peeling of Plaster on Wall No. 3 of Stair Ground Floor to First Floor,  
Part A of House No. 2414, Ground Floor

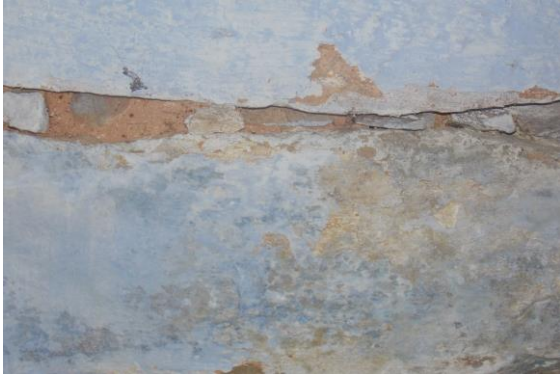
Photo 53

Peeling of Plaster on Roof of Stair Ground Floor to First Floor, Part A of  
House No. 2414, Ground Floor

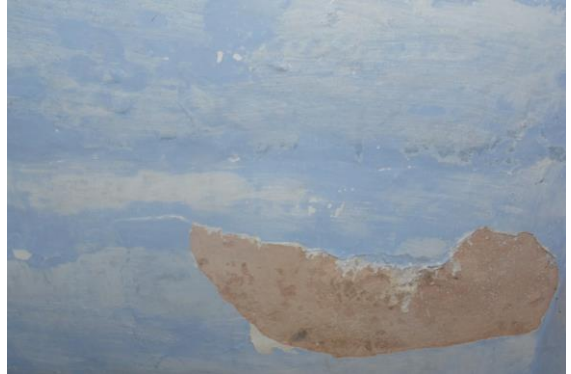
Photo 54

Peeling of Plaster on Roof of Stair Ground Floor to First Floor, Part A of  
House No. 2414, Ground Floor

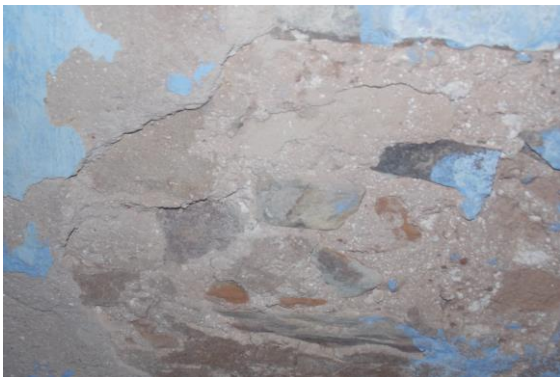
Photo 55

Peeling of Plaster on Wall No. 2 of Stair Ground Floor to First Floor,  
Part A of House No. 2414, Ground Floor

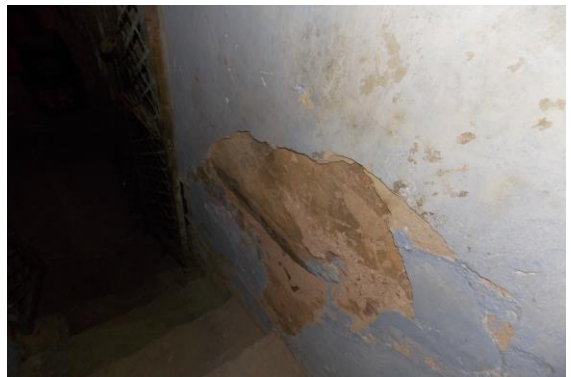
Photo 56

Peeling of Plaster on Wall No. 2 of Stair Ground Floor to First Floor,  
Part A of House No. 2414, Ground Floor

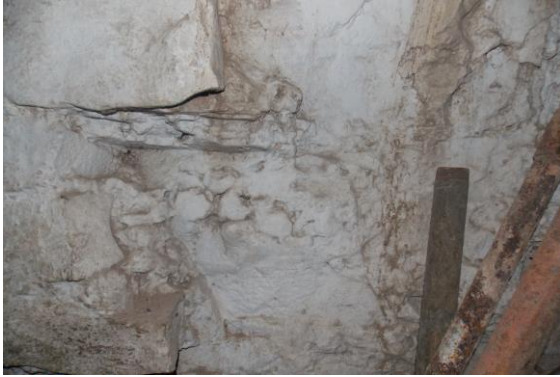
Photo 57

Peeling of Plaster on Wall No. 2 of Passage 1, Part A of House No. 2414, Ground Floor

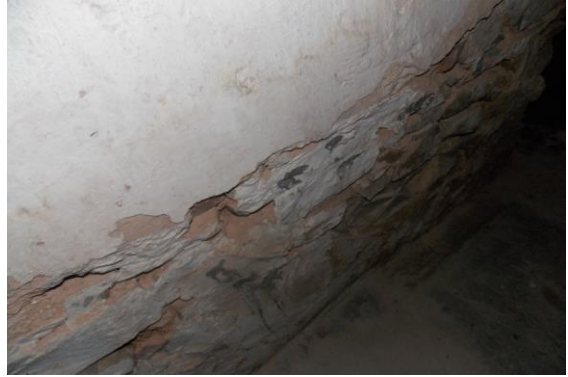
Photo 58

Peeling of Plaster on Wall No. 1 of Passage 1, Part A of House No. 2414, Ground Floor

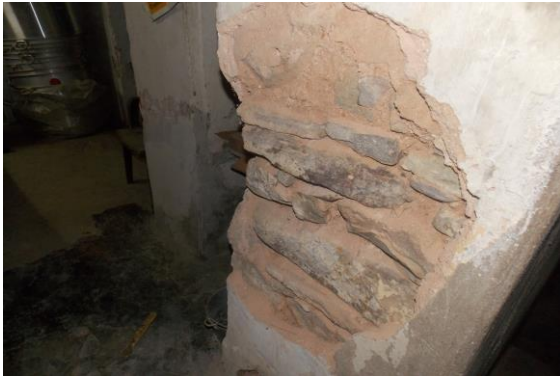
Photo 59

Peeling of Plaster on Wall No. 2 of Room No. 1 of House No. 2414, Ground Floor

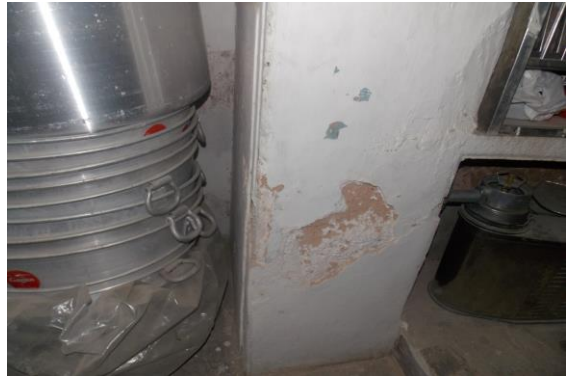
Photo 60

Peeling of Plaster on Wall No. 4 of Room No. 1 of House No. 2414, Ground Floor

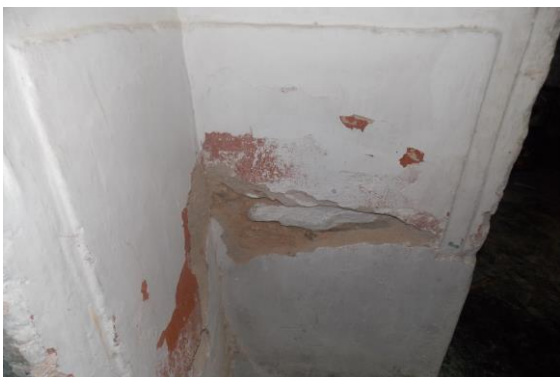
Photo 61

Peeling of Plaster on Wall No. 3 of Room No. 1 of House No. 2414, Ground Floor

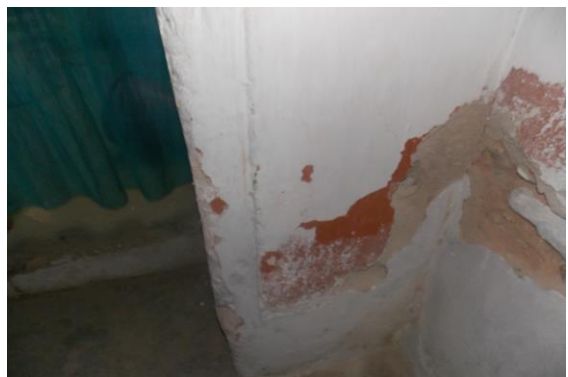
Photo 62

Peeling of Plaster on Wall No. 2 of Room No. 1 of House No. 2414, Ground Floor

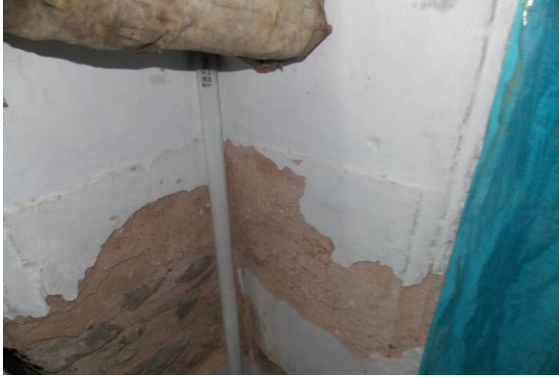
Photo 63

Peeling of Plaster on Wall No. 2 & 3 of Room No. 2 of House No. 2414, Ground Floor

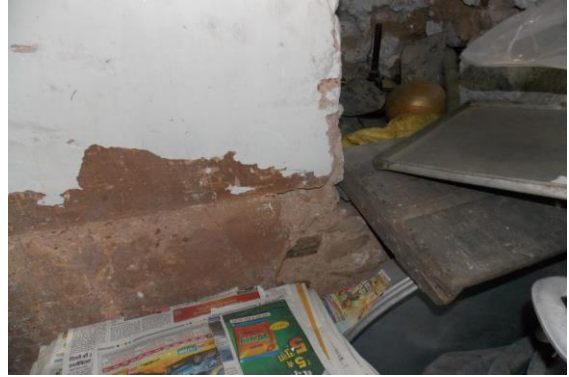
Photo 64

Peeling of Plaster on Wall No. 1 of Room No. 2 of House No. 2414, Ground Floor

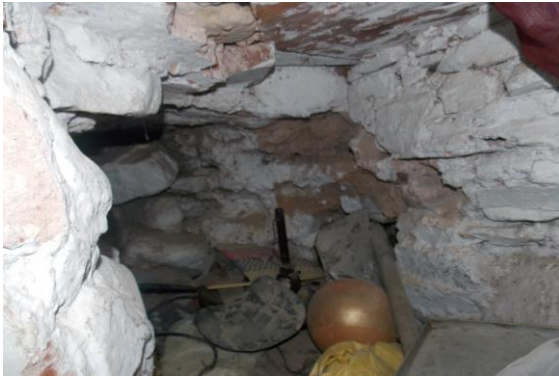
Photo 65

Damaged Portion on Wall No. 1 of Room No. 2 of House No. 2414, Ground Floor

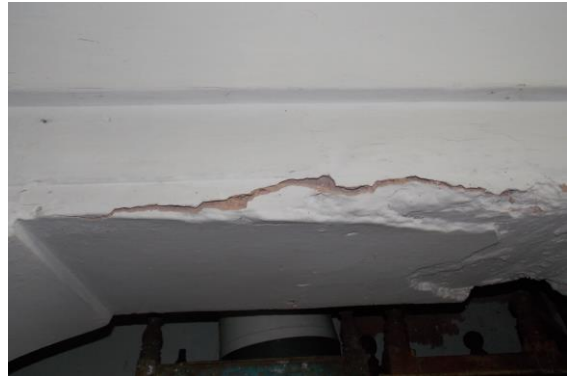
Photo 66

Peeling of Plaster on Wall No. 4 of Room No. 2 of House No. 2414, Ground Floor

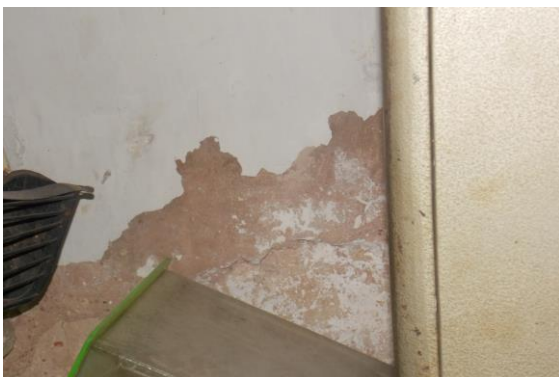
Photo 67

Peeling of Plaster on Wall No. 4 of Room No. 2 of House No. 2414, Ground Floor

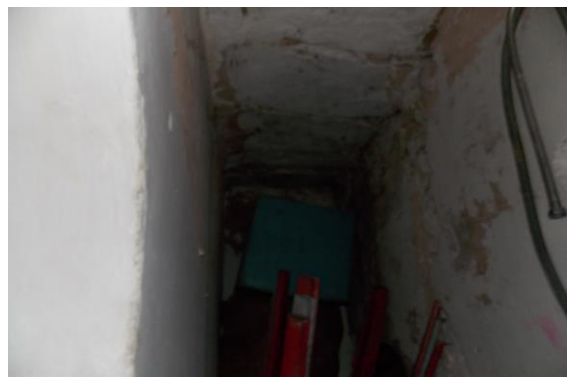
Photo 68

Peeling of Plaster on Roof & Wall No. 1, 3 & 4 of Store Room, Part A of House No. 2414, Ground Floor

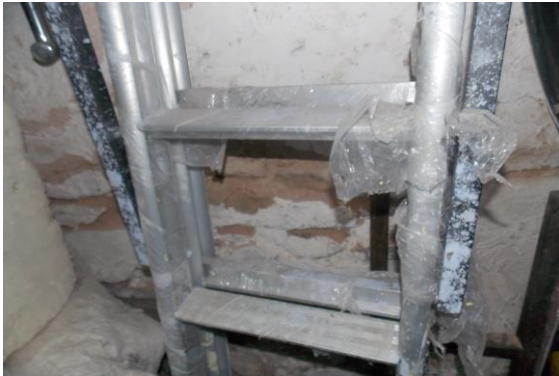
Photo 69

Peeling of Plaster on Wall No. 4 of Store Room ,Part A of House No. 2414, Ground Floor

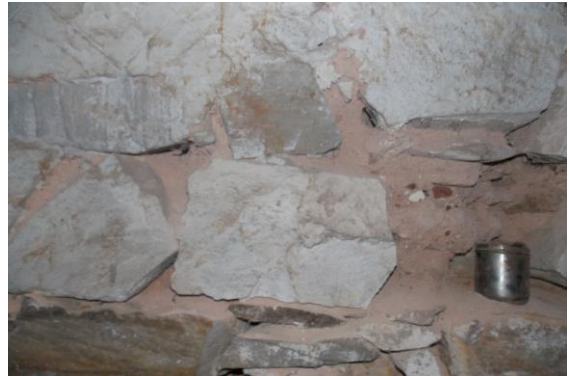
Photo 70

Peeling of Plaster on Wall No. 2 of Passage , Part A of House No. 2414, Ground Floor

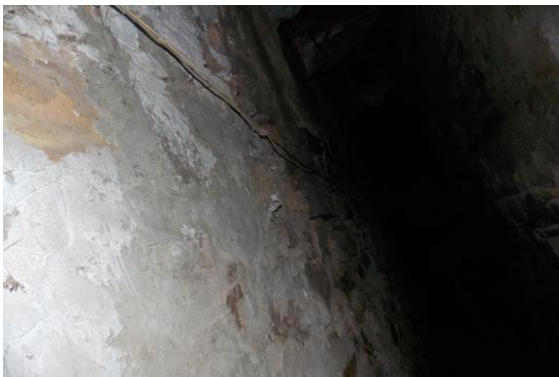
Photo 71

Damaged Portion on Wall No. 1 of Passage , Part A of House No. 2414, Ground Floor

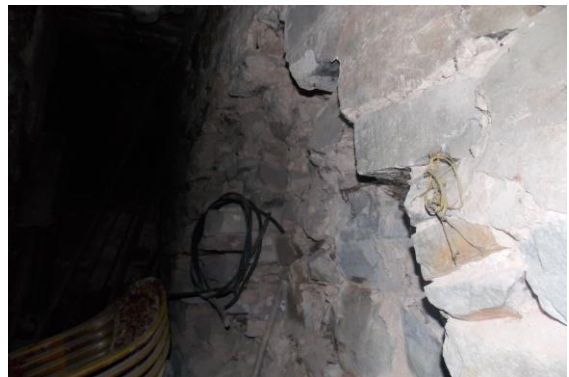
Photo 72

Damaged Portion on Wall No. 2 of Passage , Part A of House No. 2414, Ground Floor

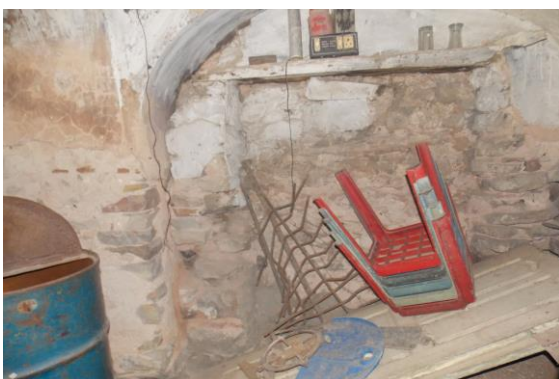
Photo 73

Damaged Portion on All Wall & Roof of Room No. 3 of House No. 2414,Ground Floor

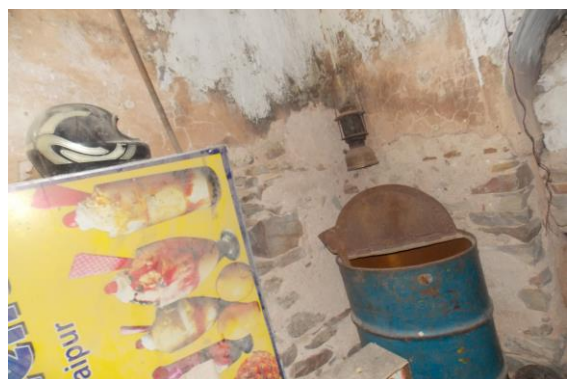
Photo 74

Damaged Portion on All Wall & Roof of Room No. 3 of House No. 2414,Ground Floor

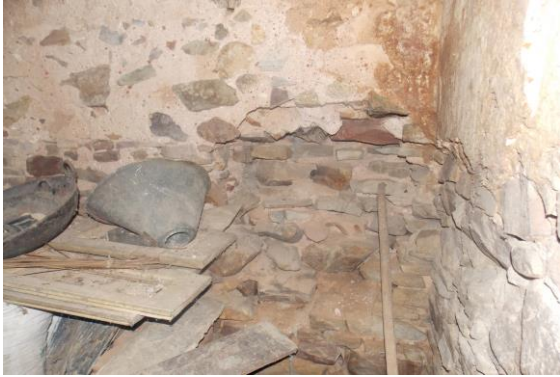
Photo 75

Damaged Portion on All Wall & Roof of Room No. 3 of House No. 2414, Ground Floor

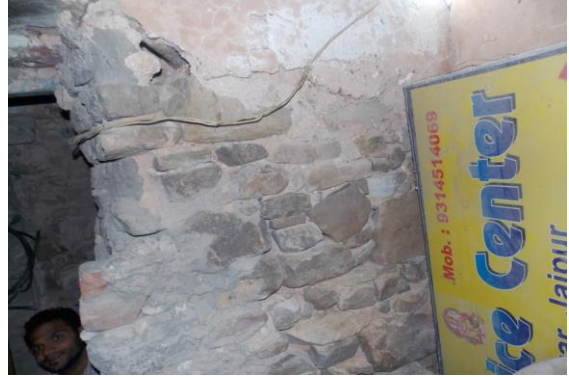
Photo 76

Damaged Portion on All Wall & Roof of Room No. 3 of House No. 2414, Ground Floor

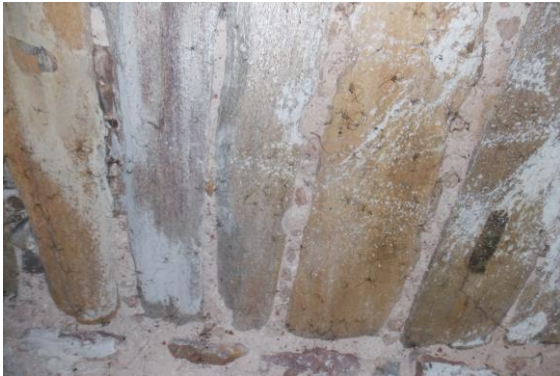
Photo 77

Damaged Portion on All Wall & Roof of Room No. 3 of House No. 2414, Ground Floor

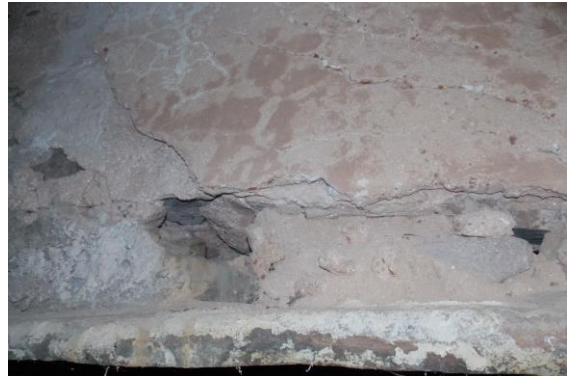
Photo 78

Damaged Portion on All Wall & Roof of Room No. 3 of House No. 2414, Ground Floor

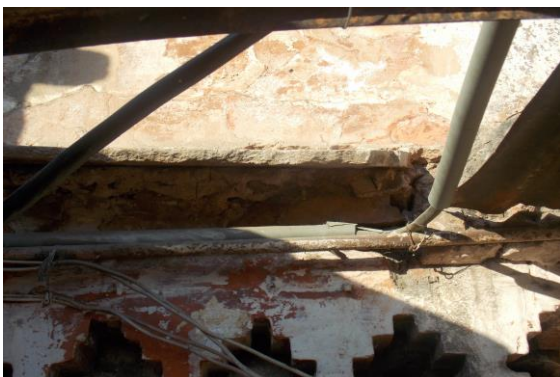
Photo 79

Peeling of Plaster on Wall No. 4 of Varanda 3 of Part A of House No. 2414, Ground Floor

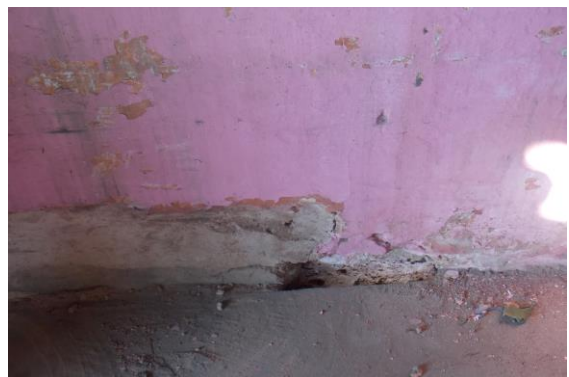
Photo 80

Damaged Portion on Wall No. 3 of Varanda 3 of Part A of House No. 2414, Ground Floor

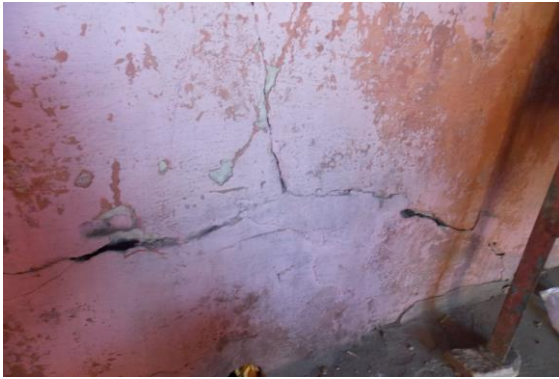
Photo 81

Damaged Portion on Wall No. 2 of Varanda 3 of Part A of House No. 2414, Ground Floor

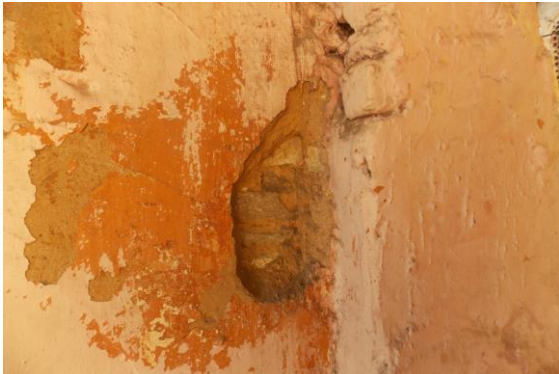
Photo 82

Damaged Portion on Wall No. 2 of Varanda 3 of Part A of House No. 2414, Ground Floor

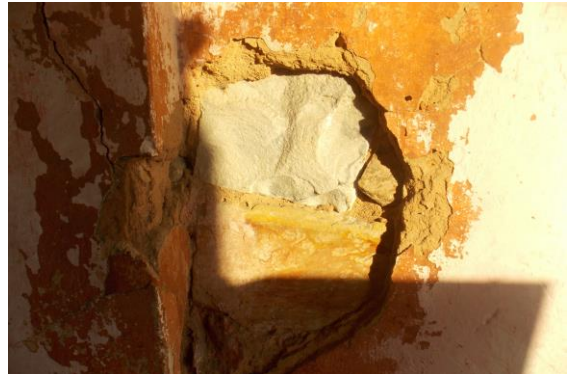
Photo 83

Peeling of Plaster on Wall No. 1 of Staircase of Part A of House No. 2414, Ground Floor

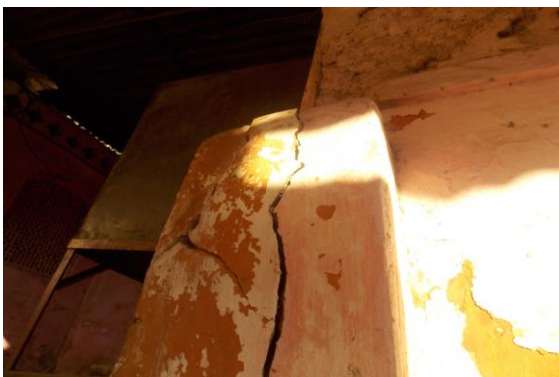
Photo 84

Peeling of Plaster on Wall No. 2 of House No. 2414 of House No. 2414, Ground Floor

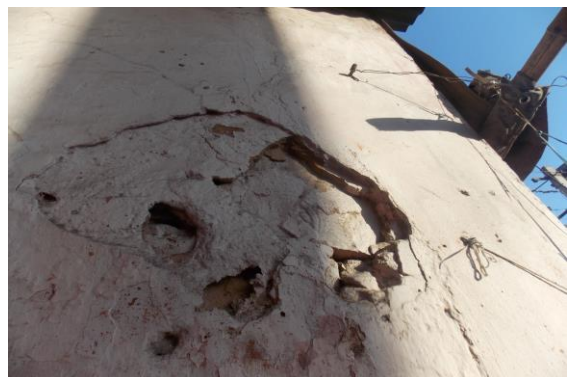
Photo 85

Damaged Portion on Wall No. 2 of House No. 2414 of House No. 2414, Ground Floor

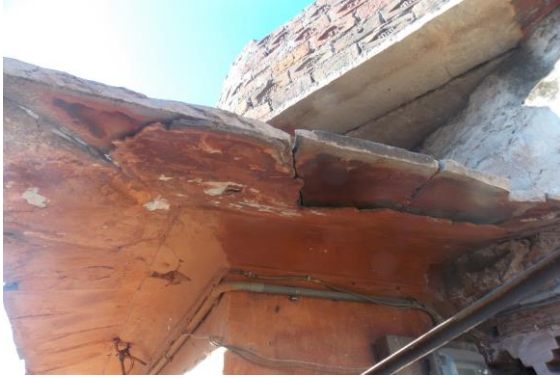
Photo 86

Damaged Portion on Wall No. 2 of House No. 2414 of House No. 2414, Ground Floor

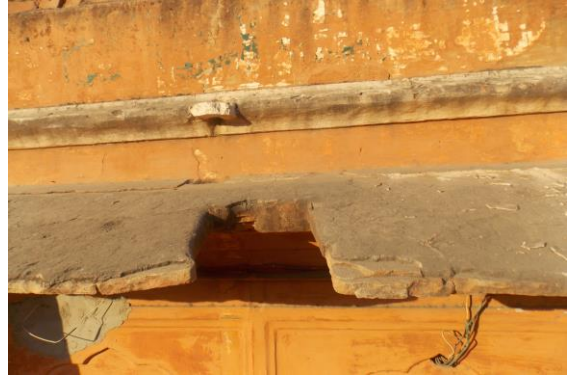
Photo 87

Damaged Portion on Wall No. 4 & Sunshade of Varanda 3 of Part A of House No. 2414, Ground Floor

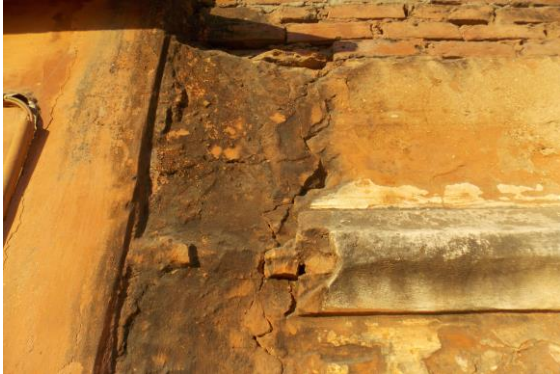
Photo 88

Damaged Portion on Wall No. 4 & Sunshade of Varanda 3 of Part A of House No. 2414, Ground Floor

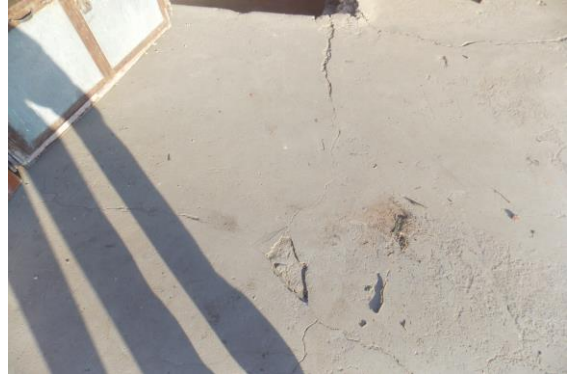
Photo 89

Peeling of Plaster on Wall No. 4 of Varanda 3 of Part A of House No. 2414, Ground Floor

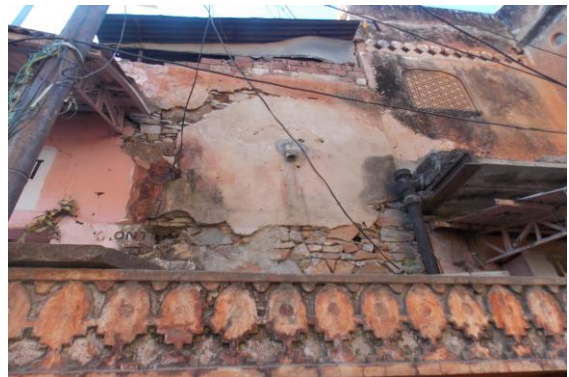
Photo 91

Damaged Portion on Sunshade of Main Gate of House No. 2414, Ground Floor

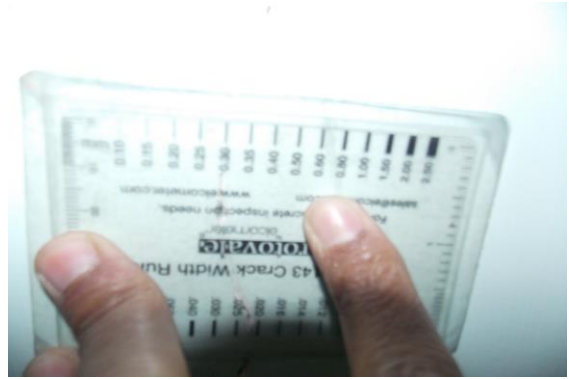
Photo 13

Inclined Crack on Roof of Hall No. 4, First Floor  
Approx. Width = 0.4mm, Approx. Length = 1m.  
Distance from Wall No.2 = 2.2m, Height from Floor = 2.2m.

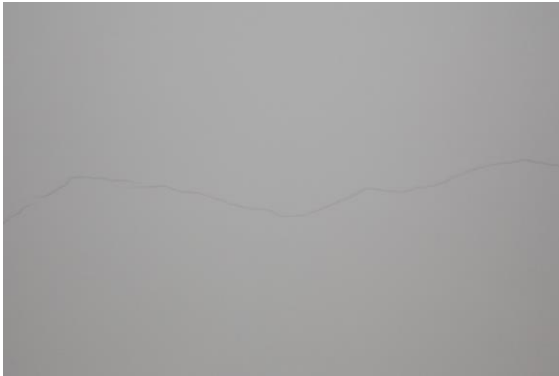
Photo 13A

Inclined Crack on Roof of Hall No. 4, First Floor  
Approx. Width = 0.4mm, Approx. Length = 1m.  
Distance from Wall No.2 = 2.2m, Height from Floor = 2.2m.

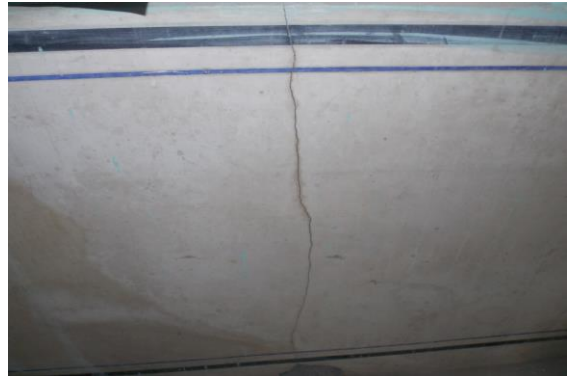
Photo 14

Inclined Crack on Roof of Hall No. 6, First Floor  
Approx. Width = 0.5mm, Approx. Length = 2m.

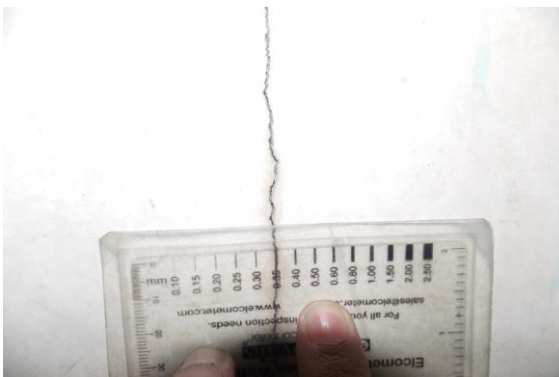
Photo 15

Inclined Crack on Wall No. 1 of Room No. 1, Second Floor  
Approx. Width = 0.35mm, Approx. Length = 1.1m.  
Distance from Wall No.3 = 1.3m, Height from Floor = 0m.

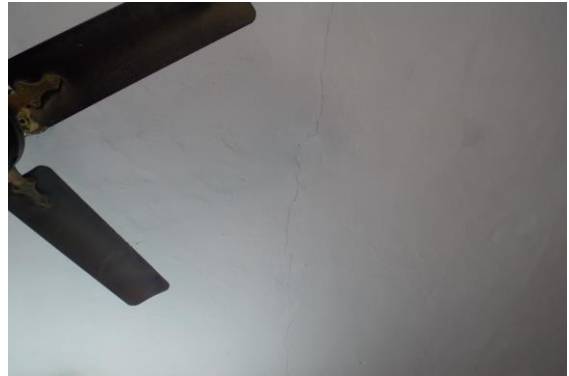
Photo 17

Inclined Crack on Roof of Toilet No. Toilet & Bathroom No.3, Second Floor, Approx. Width = 0.3mm, Approx. Length = 2m.

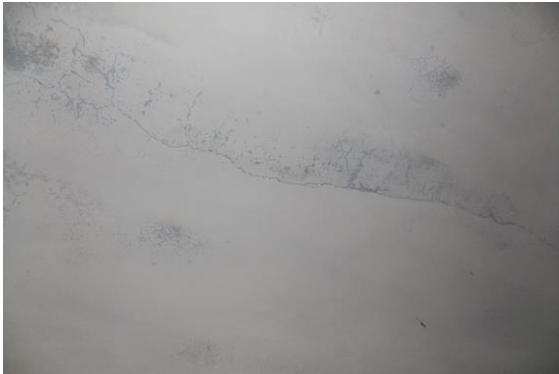
Photo 18

Inclined Crack on Roof of Room No. 1, Second Floor  
Approx. Width = 0.3mm, Approx. Length = 1m.

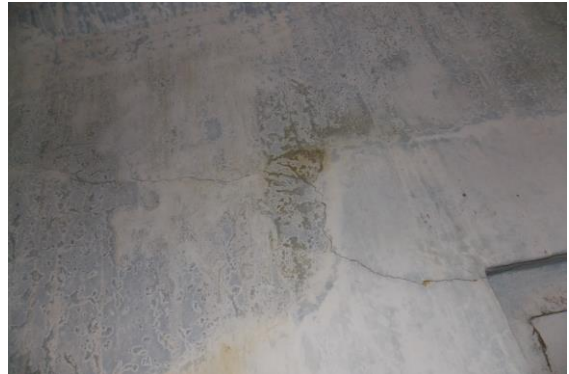
Photo 19

Inclined Crack on Roof of Room No. 2, Second Floor  
Approx. Width = 0.4mm, Approx. Length = 2m.

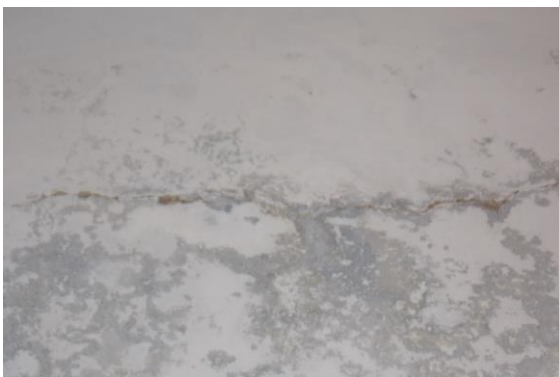
Photo 20

Inclined Crack on Wall No. 2 of Room No. 2, Second Floor  
Approx. Width = 0.4mm, Approx. Length = 1.3m.  
Distance from Wall No.3 = 1m, Height from Floor = 2.1m.

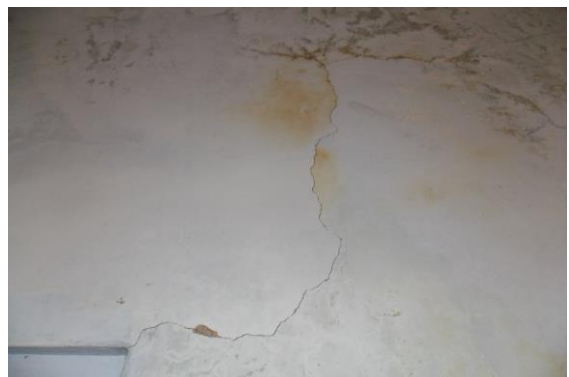
Photo 21

Inclined Crack on Wall No. 4 of Room No. 3, Second Floor  
Approx. Width = 0.5mm, Approx. Length = 2m.

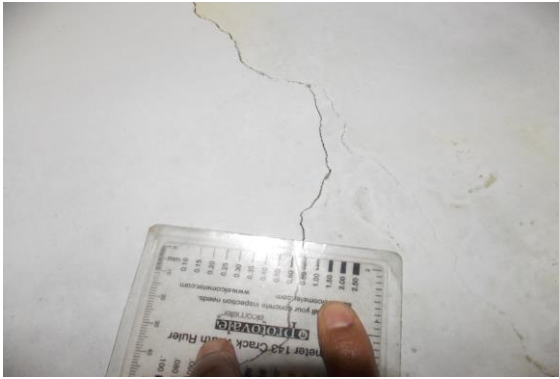
Photo 22

Inclined Crack on Wall No. 5 of Room No. 3, Second Floor  
Approx. Width = 0.8mm, Approx. Length = 1.2m.  
Distance from Wall No.6 = 1.1m, Height from Floor = 2m.

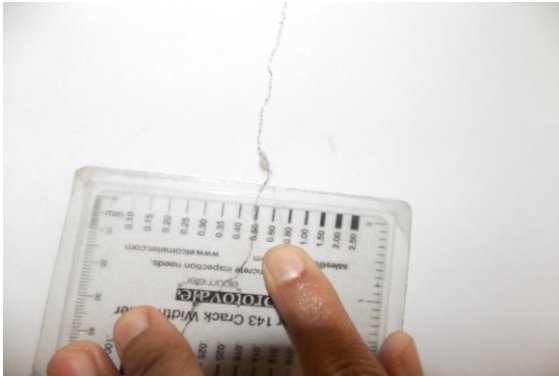
Photo 23

Inclined Crack on Wall No. 2 of Room No. 3, Second Floor  
Approx. Width = 0.5mm, Approx. Length = 1.6m.  
Distance from Wall No.4 = 0m, Height from Floor = 1.9m.

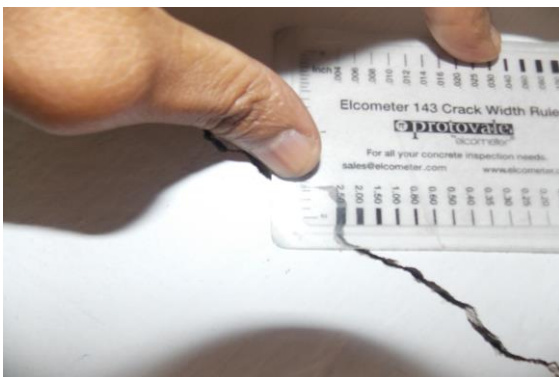
Photo 24A

Inclined Crack on Wall No. 3 of Room No. 3, Second Floor  
Approx. Width = 2.5mm, Approx. Length = 0.8m.  
Distance from Wall No.2 = 0.4m, Height from Floor = 1.9m.

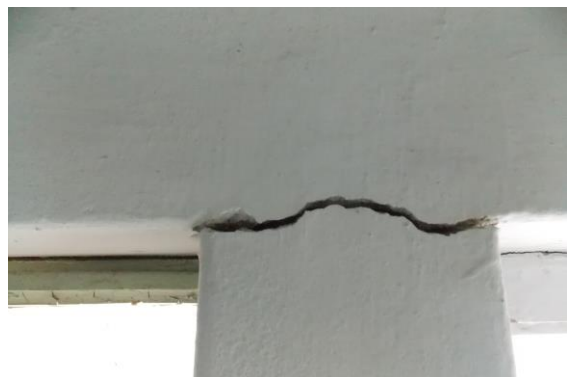
Photo 25

Horizontal Crack on Wall No. 3 of Part A of H. No.2193, Second Floor, Approx. Width = 4mm, Approx. Length = 0.3m.  
Distance from Wall No.2 = 1.3m, Height from Floor = 1.9m.

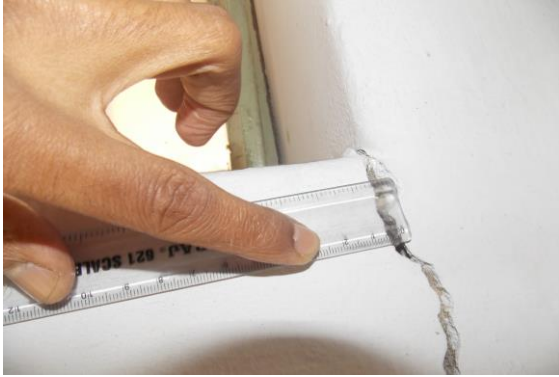
Photo 25A

Horizontal Crack on Wall No. 3 of Part A of H. No.2193, Second Floor, Approx. Width = 4mm, Approx. Length = 0.3m.  
Distance from Wall No.2 = 1.3m, Height from Floor = 1.9m.

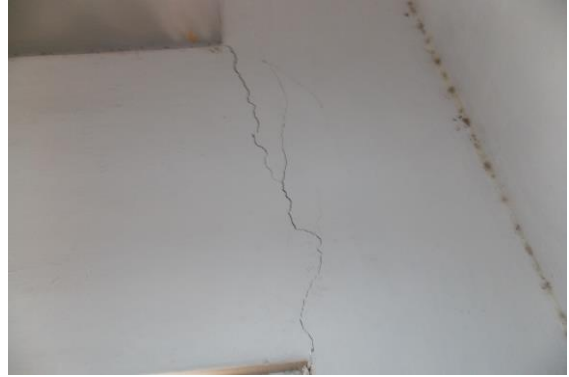
Photo 26

Inclined Crack on Wall No. 3 of Room No. 3, Second Floor  
Approx. Width = 1mm, Approx. Length = 1m.  
Distance from Wall No.1 = 0.25m, Height from Floor = 1.9m.

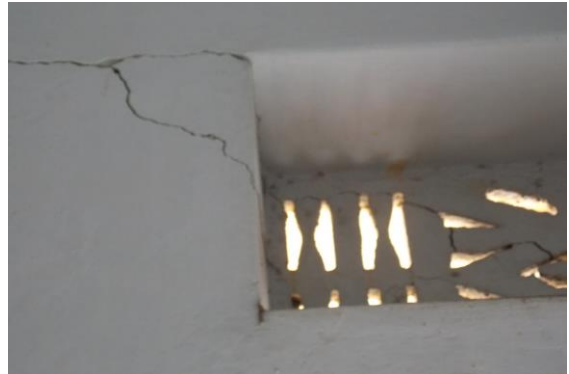
Photo 27

Inclined Crack on Wall No. 3 of Room No. 3, Second Floor  
Approx. Width = 2mm, Approx. Length = 1m.  
Distance from Wall No.1 = 0.3m, Height from Floor = 2.6m.

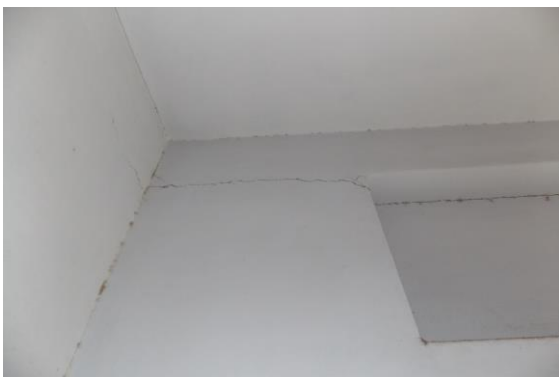
Photo 28

Horizontal Crack on Wall No. 2 & 3 of Room No. 3, Second Floor  
Approx. Width = 2mm, Approx. Length = 0.6m.  
Distance from Wall No.2 = 0.4m, Height from Floor = 2.6m.

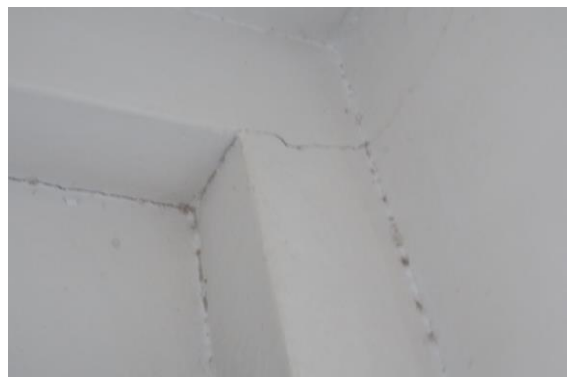
Photo 29

Horizontal Crack on Wall No. 3 of Room No. 4, Second Floor  
Approx. Width = 1mm, Approx. Length = 0.4m.  
Distance from Wall No.1 = 0m, Height from Floor = 2.6m.

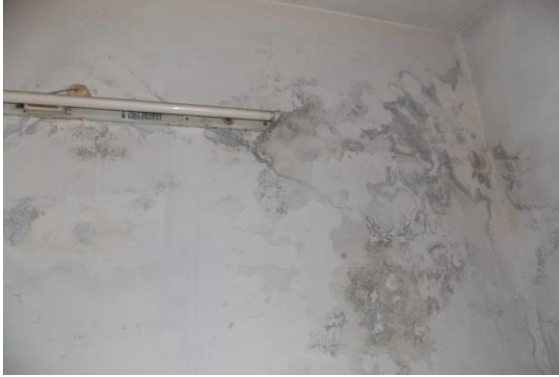
Photo 30

Inclined Crack on Wall No. 2 & 4 of Room No. 5, Second Floor  
Approx. Width = 1.5mm, Approx. Length = 3m.  
Distance from Wall No.1 = 1.7m, Height from Floor = 0.6m.

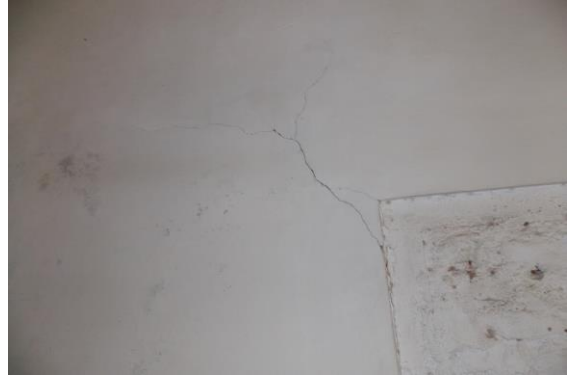
Photo 30A

Inclined Crack on Wall No. 2 & 4 of Room No. 5, Second Floor  
Approx. Width = 1.5mm, Approx. Length = 3m.  
Distance from Wall No.1 = 1.7m, Height from Floor = 0.6m.

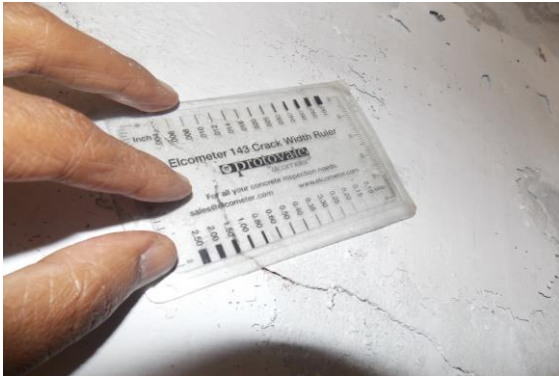
Photo 30A

Inclined Crack on Wall No. 2 & 4 of Room No. 5, Second Floor  
Approx. Width = 1.5mm, Approx. Length = 3m.  
Distance from Wall No.1 = 1.7m, Height from Floor = 0.6m.

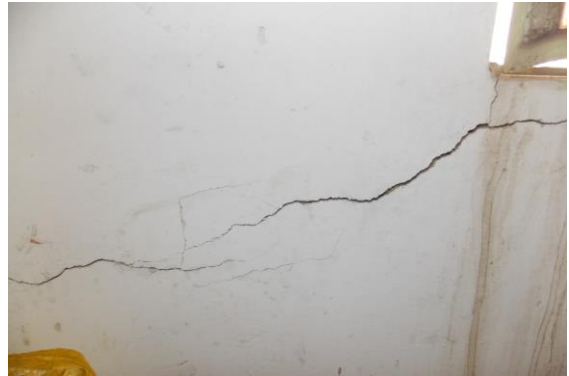
Photo 31

Inclined Crack on Wall No. 3 of Room No. 5, Second Floor  
Approx. Width = 2mm, Approx. Length = 1m.  
Distance from Wall No.1 = 0.8m, Height from Floor = 0.6m.

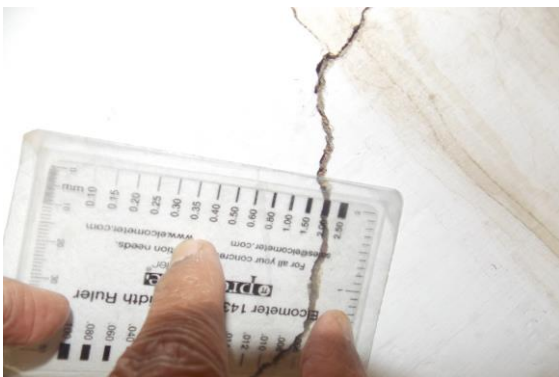
Photo 31A

Inclined Crack on Wall No. 3 of Room No. 5, Second Floor  
Approx. Width = 2mm, Approx. Length = 1m.  
Distance from Wall No.1 = 0.8m, Height from Floor = 0.6m.

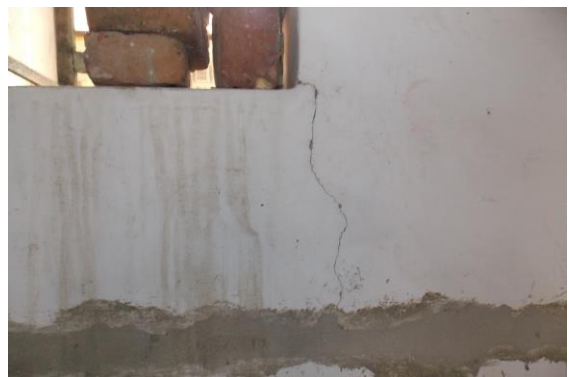
Photo 32

Inclined Crack on Wall No. 4 of Room No. 5, Second Floor  
Approx. Width = 0.6mm, Approx. Length = 1.1m.  
Distance from Wall No.1 = 0.8m, Height from Floor = 0m.

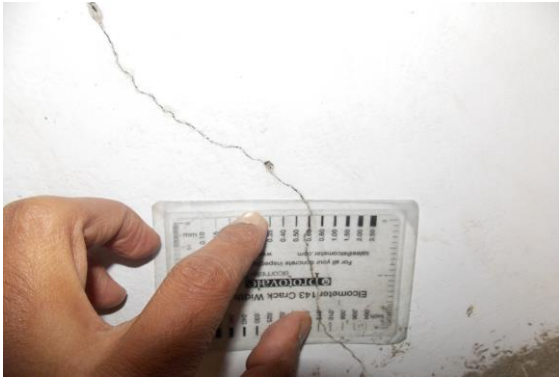
Photo 32A

Inclined Crack on Wall No. 4 of Room No. 5, Second Floor  
Approx. Width = 0.6mm, Approx. Length = 1.1m.  
Distance from Wall No.1 = 0.8m, Height from Floor = 0m.

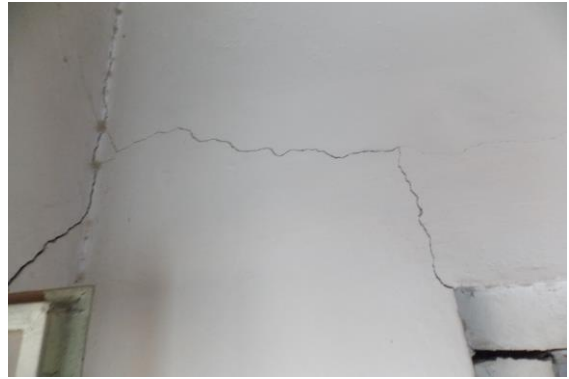
Photo 33

Inclined Crack on Wall No. 1 of Room No. 5, Second Floor  
Approx. Width = 1mm, Approx. Length = 0.6m.  
Distance from Wall No.3 = 0.25m, Height from Floor = 1.9m.

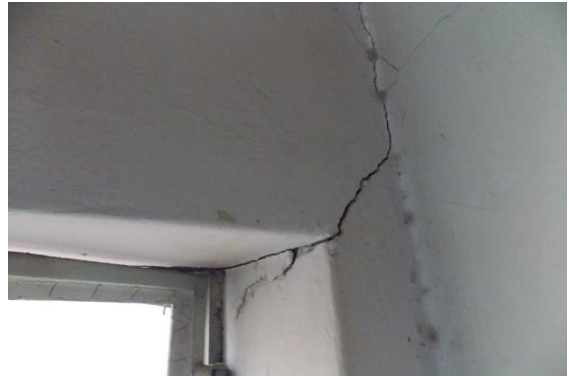
Photo 34

Inclined Crack on Wall No. 3 of Room No. 5, Second Floor  
Approx. Width = 2.5mm, Approx. Length = 0.6m.  
Distance from Wall No.1 = 0.15m, Height from Floor = 1.9m.

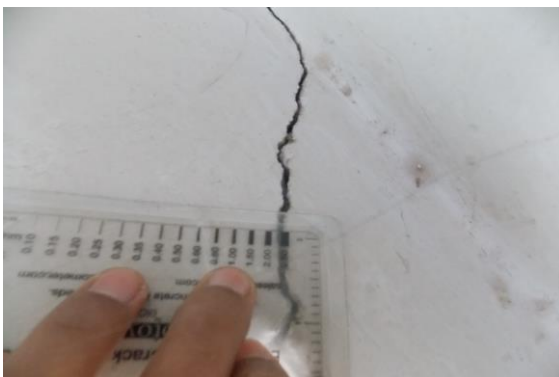
Photo 34A

Inclined Crack on Wall No. 3 of Room No. 5, Second Floor  
Approx. Width = 2.5mm, Approx. Length = 0.6m.  
Distance from Wall No.1 = 0.15m, Height from Floor = 1.9m.

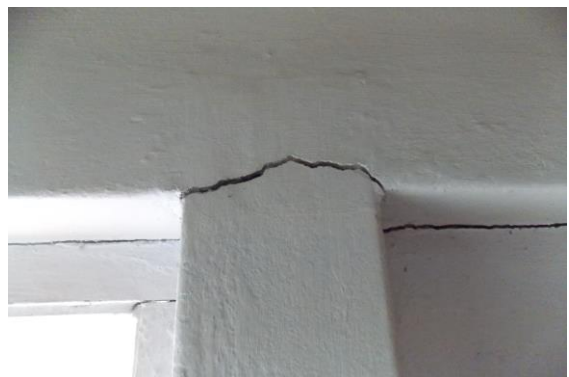
Photo 35

Horizontal Crack on Wall No. 3 of Room No. 5, Second Floor  
Approx. Width = 4mm, Approx. Length = 1.3m.  
Distance from Wall No.2 = 1.2m, Height from Floor = 1.9m.

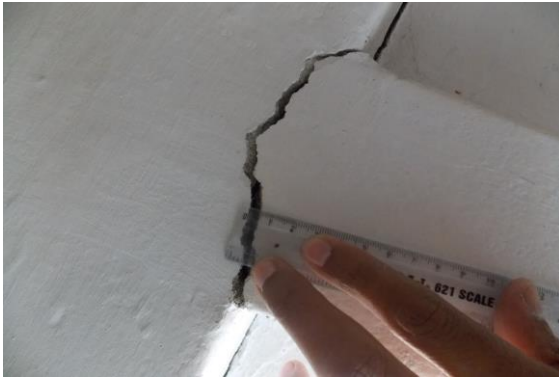
Photo 35A

Horizontal Crack on Wall No. 3 of Room No. 5, Second Floor  
Approx. Width = 4mm, Approx. Length = 1.3m.  
Distance from Wall No.2 = 1.2m, Height from Floor = 1.9m.

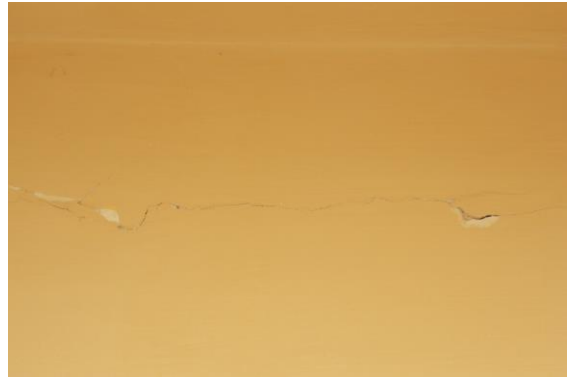
Photo 36

Inclined Crack on of Part A of H. No.2193, First Floor  
Approx. Width = 0.5mm, Approx. Length = 5m.  
Distance from Wall No.2 = 2.5m, Height from Floor = 2m.

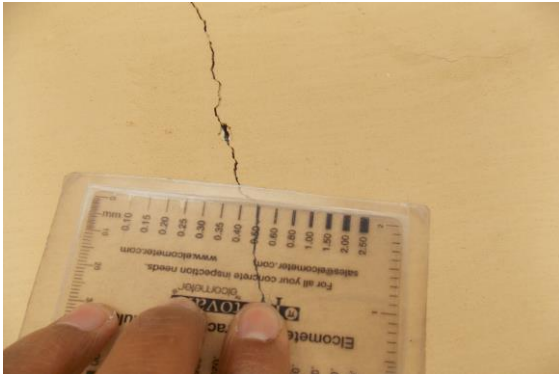
Photo 36A

Inclined Crack on of Part A of H. No.2193, First Floor  
Approx. Width = 0.5mm, Approx. Length = 5m.  
Distance from Wall No.2 = 2.5m, Height from Floor = 2m.

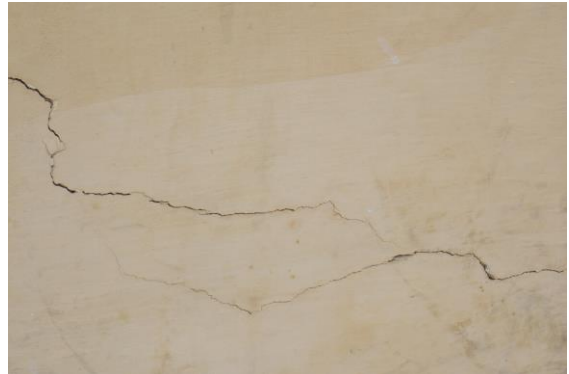
Photo 37

Inclined Crack on of Part A of H. No.2193, First Floor  
Approx. Width = 0.5mm, Approx. Length = 0.8m.  
Distance from Wall No.2 = 1.6m, Height from Floor = 0.6m.

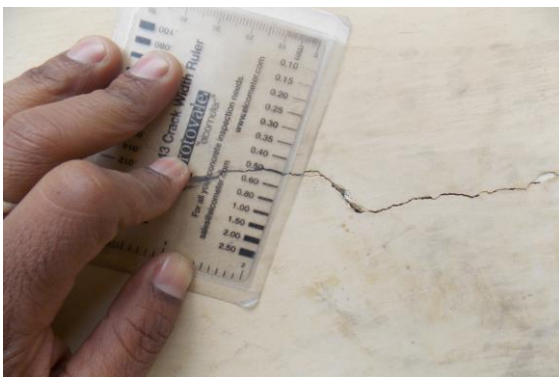
Photo 37A

Inclined Crack on of Part A of H. No.2193, First Floor  
Approx. Width = 0.5mm, Approx. Length = 0.8m.  
Distance from Wall No.2 = 1.6m, Height from Floor = 0.6m.

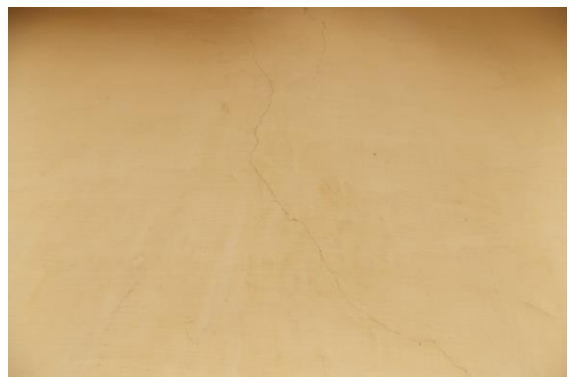
Photo 38

Inclined Crack on of Part A of H. No.2193, First Floor  
Approx. Width = 0.3mm, Approx. Length = 2m.  
Distance from Wall No.1 = 6m, Height from Floor = 1.7m.

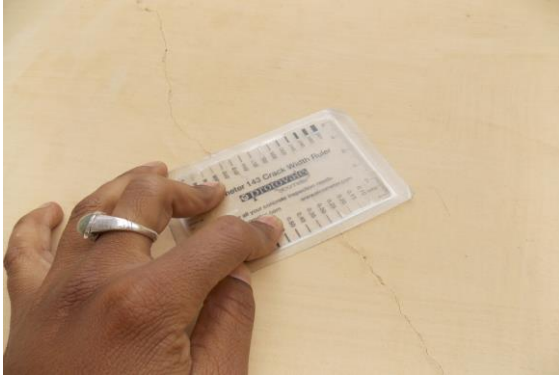
Photo 38A

Inclined Crack on of Part A of H. No.2193, First Floor  
Approx. Width = 0.3mm, Approx. Length = 2m.  
Distance from Wall No.1 = 6m, Height from Floor = 1.7m.

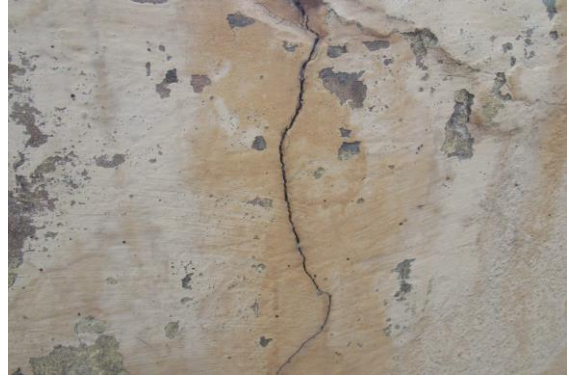
Photo 39

Inclined Crack on Wall No. Perapet Wall of Part A of H. No.2193, First Floor, Approx. Width = 1mm, Approx. Length = 1m.  
Distance from Wall No.1 = 3.5m, Height from Floor = 0m.

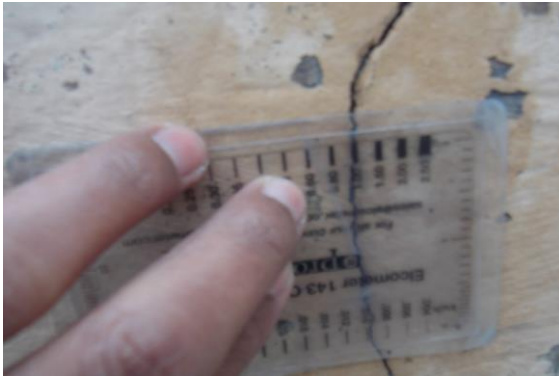
Photo 39A

Inclined Crack on Wall No. Perapet Wall of Part A of H. No.2193, First Floor, Approx. Width = 1mm, Approx. Length = 1m.  
Distance from Wall No.1 = 3.5m, Height from Floor = 0m.

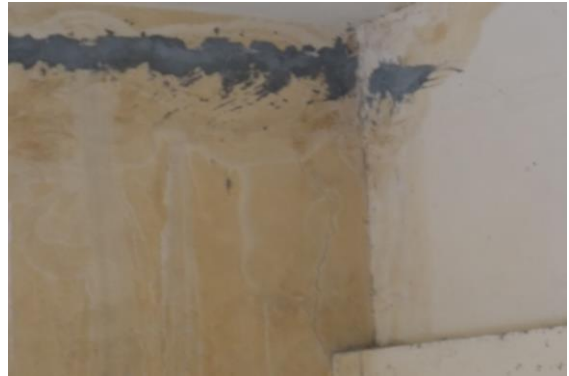
Photo 40

Inclined Crack on Wall No. 1 of Lobby, Ground Floor  
Approx. Width = 2mm, Approx. Length = 0.7m.  
Distance from Wall No.4 = 0.1m, Height from Floor = 1.9m.

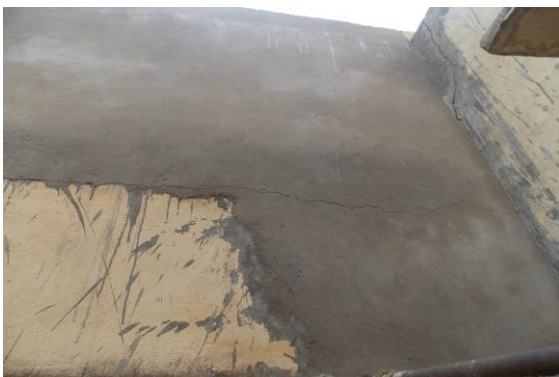
Photo 41

Horizontal Crack on Wall No. 3 of Open Sky No.2, Ground Floor  
Approx. Width = 1mm, Approx. Length = 3.5m.  
Distance from Wall no.1 = 0.6m, Height from Floor = 2.6m.

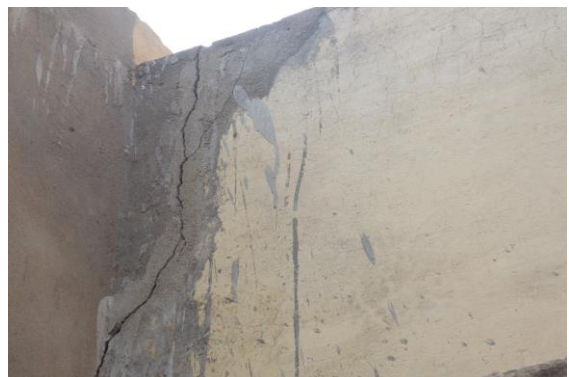
Photo 42

Inclined Crack on Wall No. 1 of Open Sky No.2, Ground Floor  
Approx. Width = 4mm, Approx. Length = 1m.  
Distance from Wall No.3 = 0m, Height from Floor = 3m.

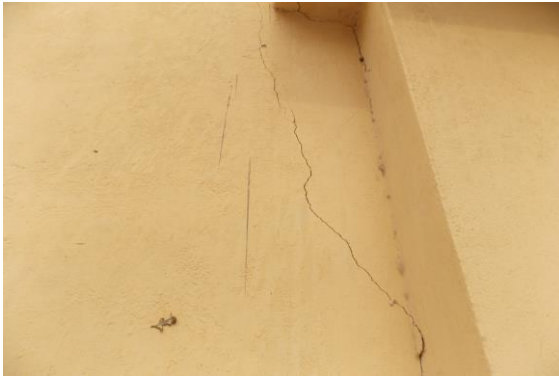
Photo 43

Inclined Crack on Wall No. 1 of Open Sky No.1, Ground Floor  
Approx. Width = 1.5mm, Approx. Length = 1.5m.  
Distance from Wall no.3 = 5.5m, Height from Floor = 1.5m.

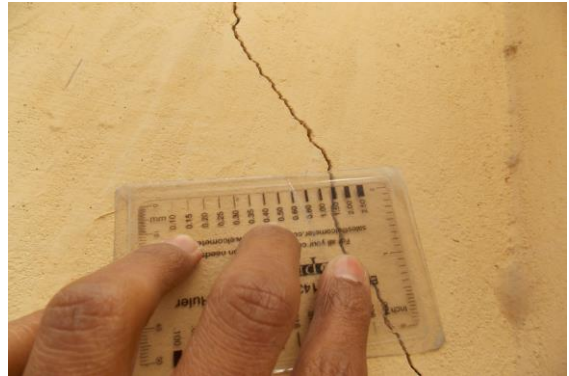
Photo 43A

Inclined Crack on Wall No. 1 of Open Sky No.1, Ground Floor  
Approx. Width = 1.5mm, Approx. Length = 1.5m.  
Distance from Wall no.3 = 5.5m, Height from Floor = 1.5m.
