### Pre Building Condition Survey Report

Name and Address of Structure :	Badi Chopar to Ramp Area (UP Line)
---------------------------------	------------------------------------

Name of the Project	<b>Contract JMRC-UG1B</b> “Design and Construction of Tunnel between Chandpole and Badi Chouper and reverse line by Shield TBM, Underground Metro Stations at Choti Chouper and Badi Chouper by Cut and Cover Methods on East West Corridor of Jaipur Metro Rail Corporation Limited .”	
Owner :

Pre Building Condition Survey Report Badi Chopar to Ramp Area (UP Line)

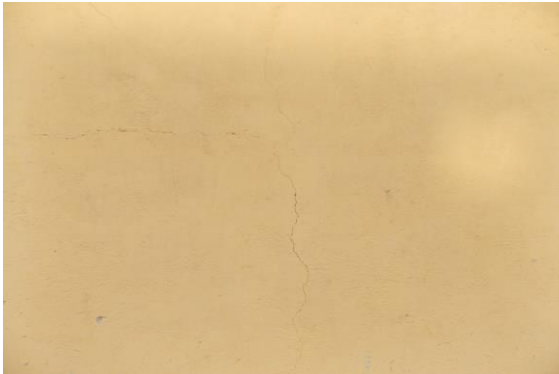
Photo 44

Inclined Crack on Wall No. 1 of Open Sky No.1, Ground Floor  
Approx. Width = 0.6mm, Approx. Length = 3m.  
Distance from Wall No.3 = 3.5m, Height from Floor = 0m.

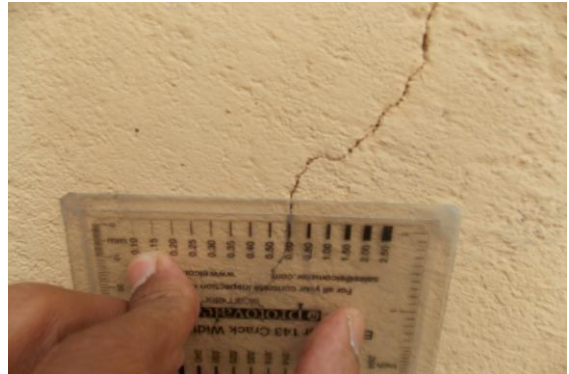
Photo 44A

Inclined Crack on Wall No. 1 of Open Sky No.1, Ground Floor  
Approx. Width = 0.6mm, Approx. Length = 3m.  
Distance from Wall No.3 = 3.5m, Height from Floor = 0m.

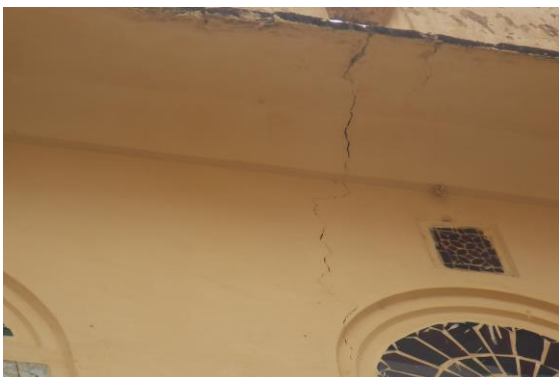
Photo 45

Inclined Crack on Outer Wall of External Façade of Part B, House No.2193, Second Floor, Approx. Width = 2.5mm, Approx. Length = 1.6m. Distance from Right External Wall = 2.7m, Height Floor = 9m.

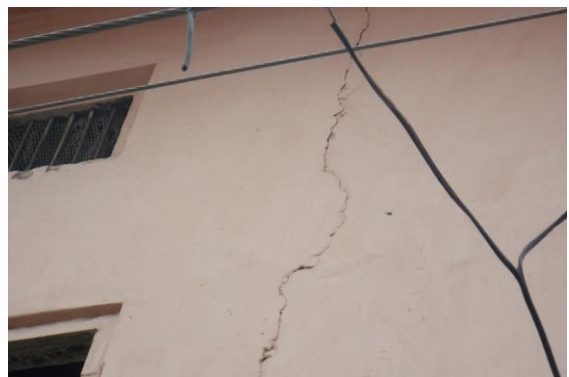
Photo 46

Inclined Crack on Outer Wall of External Façade of Part B, House No.2193, Second Floor, Approx. Width = 1mm, Approx. Length = 2.8m. Distance from Right External Wall = 5m, Height Floor = 6m.

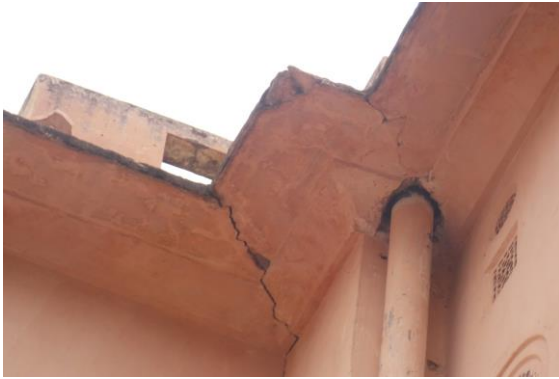
Photo 47

Horizontal Crack on Shade of External Façade of Part B, House No. 2193, Second Floor. Approx. Width = 5mm, Approx. Length = 1.7m. Distance from Left External Wall = 2m, Height Floor = 8m.

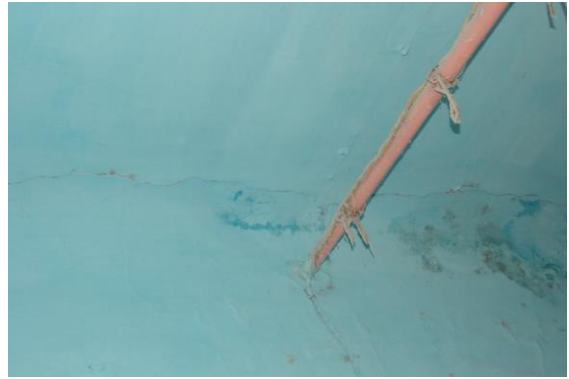
Photo 48

Horizontal Crack on Roof of Shop Jai Hind Floor Mills, Ground Floor, Approx. Width = 1mm, Approx. Length = 3m. Distance from Wall No. 1 = 0.1m, Height from Floor = 3m.

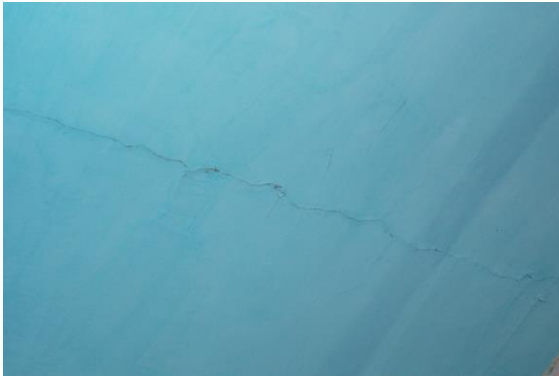
Photo 49

Horizontal Crack on Roof of Shop Jai Hind Floor Mills, Ground Floor, Approx. Width = 0.35mm, Approx. Length = 3m. Distance from Wall No. 1 = 0.4m, Height from Floor = 3m.

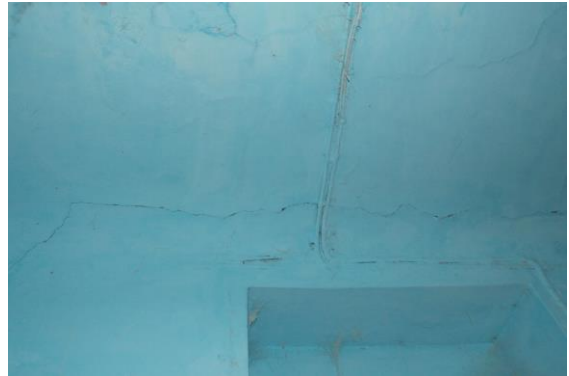
Photo 50

Horizontal Crack on Roof of Shop Jai Hind Floor Mills, Ground Floor, Approx. Width = 1mm, Approx. Length = 3m. Distance from Wall No. 1 = 0.1m, Height from Floor = 3m.

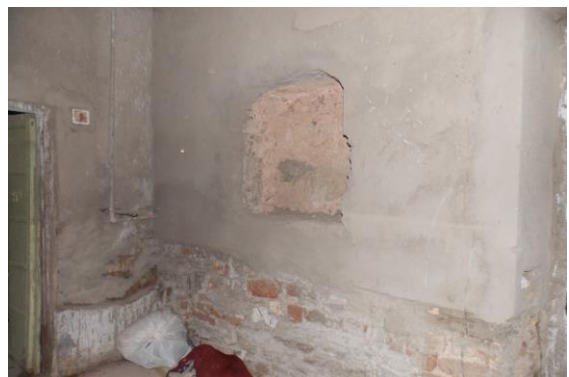
Photo 52

Damaged Portion on Wall No. 3 of Passage of Ground Floor

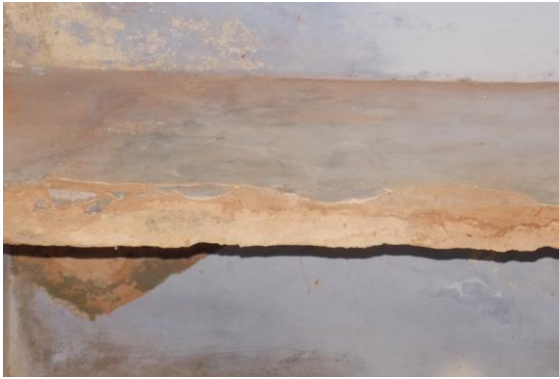
Photo 53  
Damaged Portion on Wall No. 1 of Hall No. 1 of Ground Floor

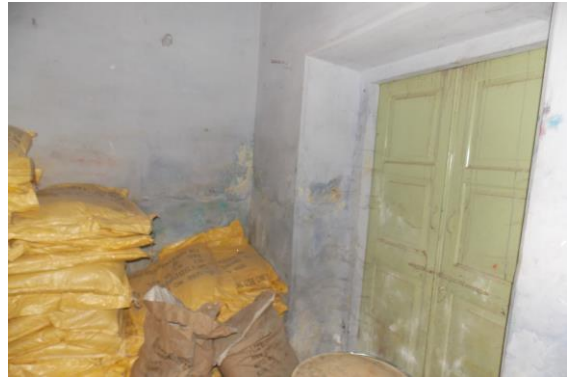
Photo 54  
Dampness/Seepage on Wall No. 2 & 3 of Hall No. 1 of Ground Floor

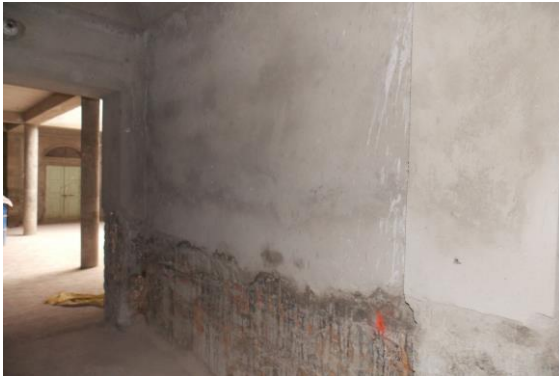
Photo 55  
Peeling of Plaster on Wall No. 5 of Passage

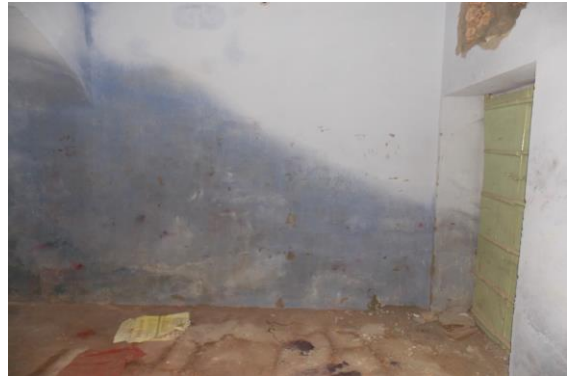
Photo 56  
Dampness/Seepage on Wall No. 2 of Room No. 1 of Ground Floor

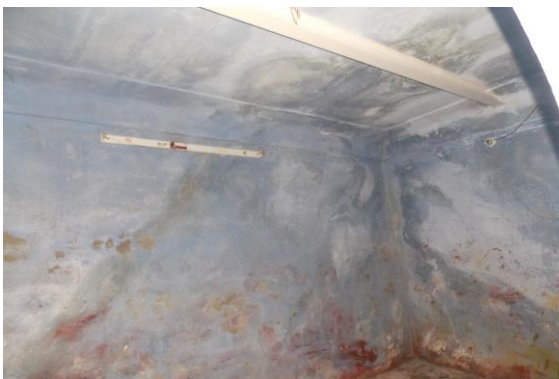
Photo 57  
Dampness/Seepage on All Walls & Roof of Room No. 2 of Ground Floor

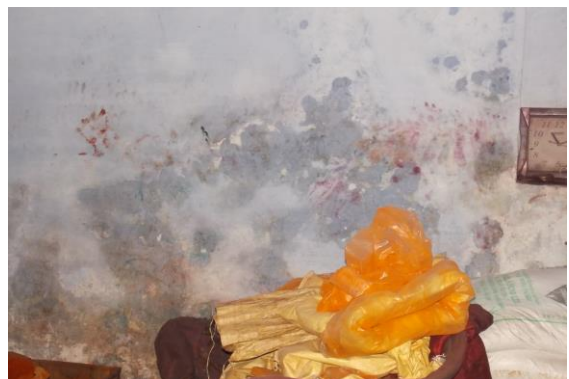
Photo 58  
Dampness/Seepage on Wall No. 4 of Hall No. 2 of Ground Floor

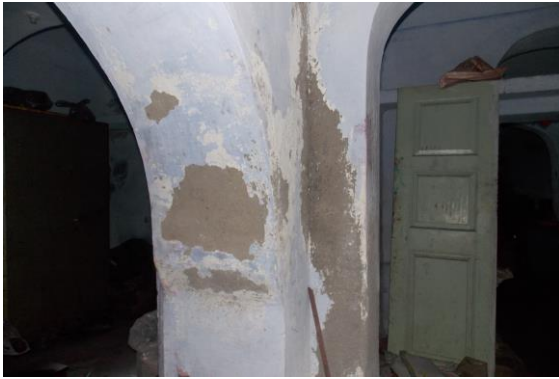
Photo 59

Damaged Portion on Wall No. 6 & 7 of Hall No. 2 of Ground Floor

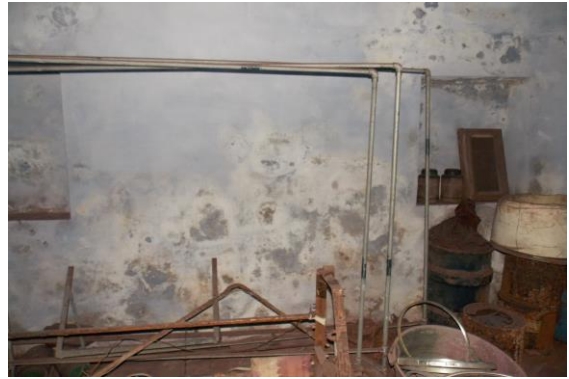
Photo 60

Dampness/Seepage on Wall No. 4 of Room No. 3 of Ground Floor

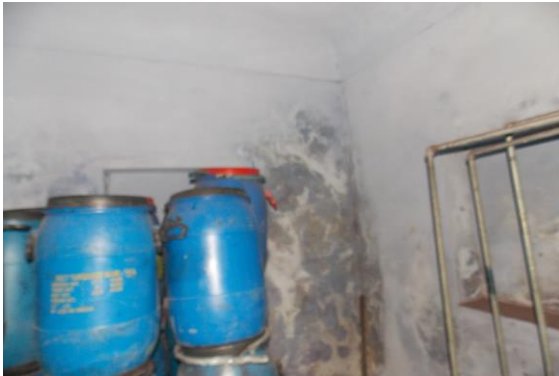
Photo 61

Dampness/Seepage on Wall No. 1 of Room No. 3 of Ground Floor

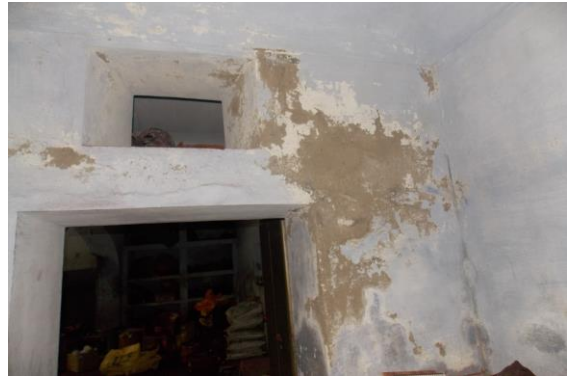
Photo 62

Damaged Portion on Wall No. 3 of Room No. 3 of Ground Floor

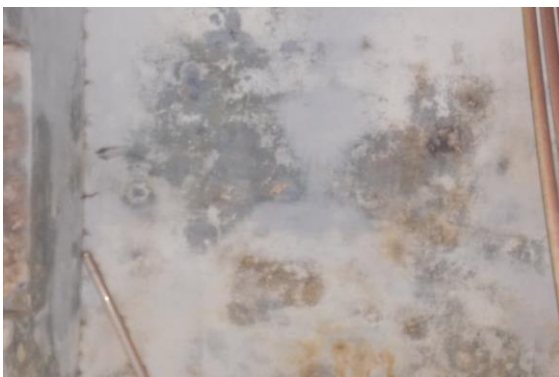
Photo 63

Dampness/Seepage on Wall No. 4 of Room No. 5 of Ground Floor

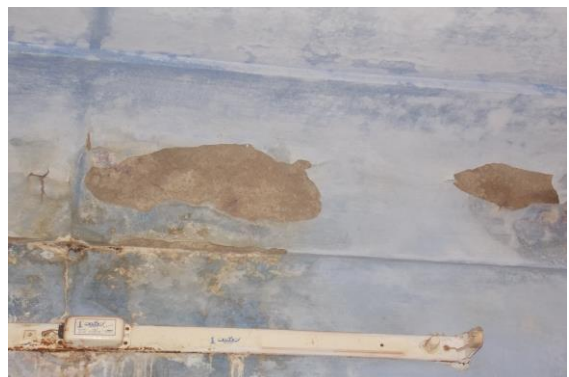
Photo 64

Peeling of Plaster on Wall No. 4 of Hall No. 3 of Ground Floor

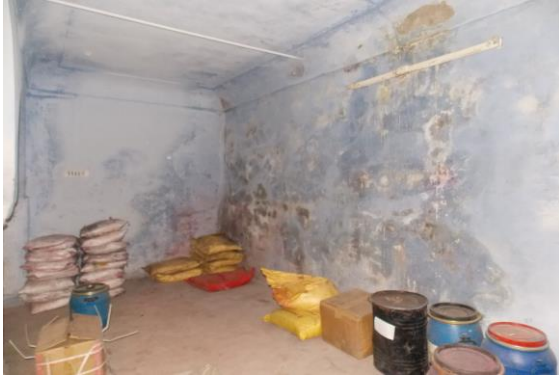
Photo 65

Dampness/Seepage on Wall No. 1 & 4 of Hall No. 3 of Ground Floor

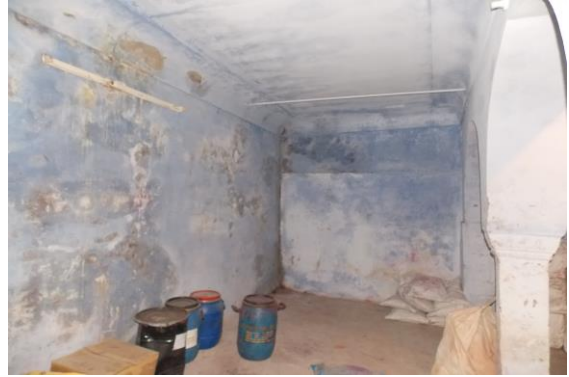
Photo 66

Dampness/Seepage on Wall No. 2 & 4 of Hall No. 3 of Ground Floor

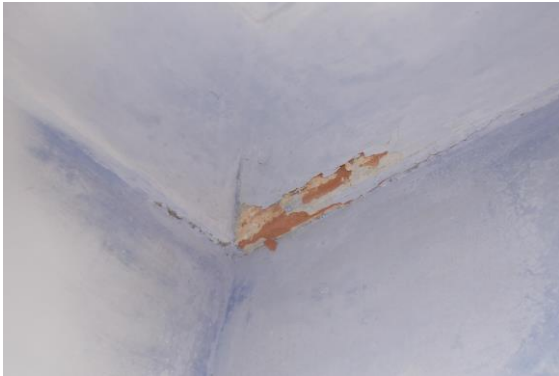
Photo 67

Peeling of Plaster on Roof of Hall No. 3 of Ground Floor

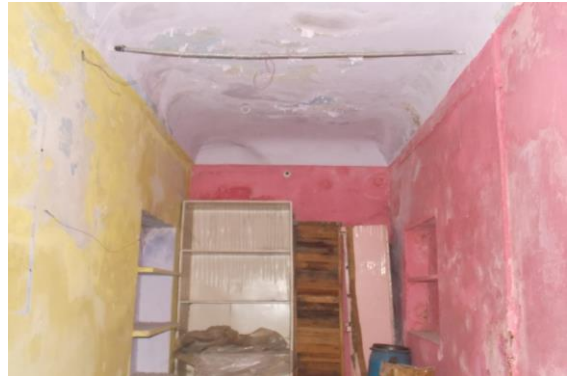
Photo 68

Dampness/Seepage on All Walls & Roof of Room No. 6 of Ground Floor

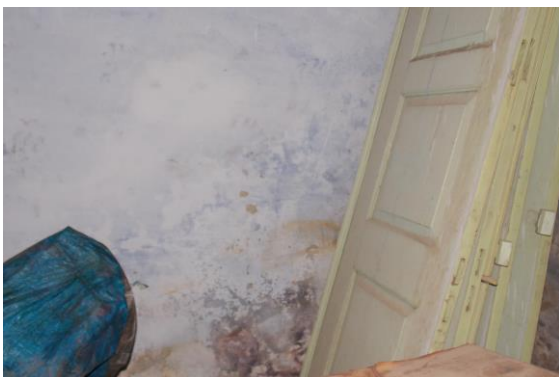
Photo 69

Dampness/Seepage on Wall No. 4 of Room No. 7 of Ground Floor

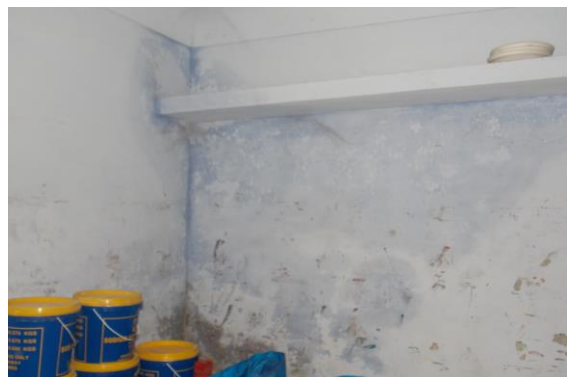
Photo 70

Dampness/Seepage on Wall No. 2 & 4 of Hall No. 4 of Ground Floor

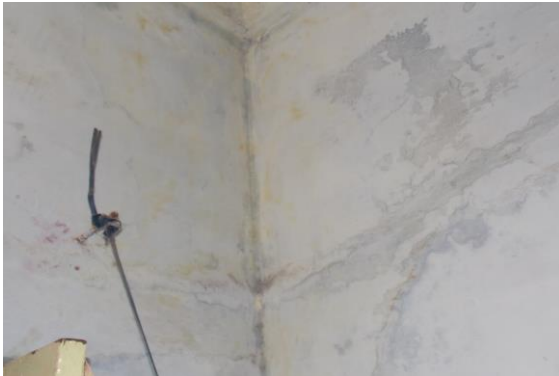
Photo 71

Dampness/Seepage on Wall No. 1 & 3 of Room No. 8 of Ground Floor

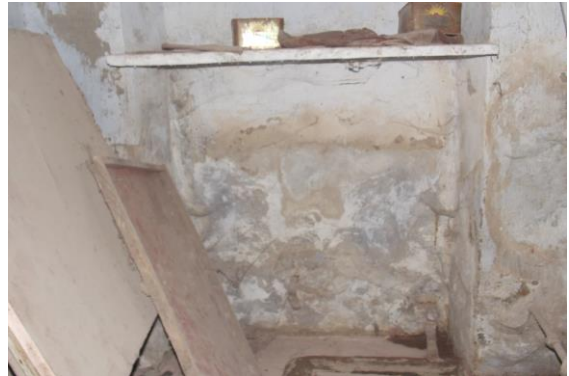
Photo 72

Dampness/Seepage on Wall No. 4 of Room No. 9 of Ground Floor

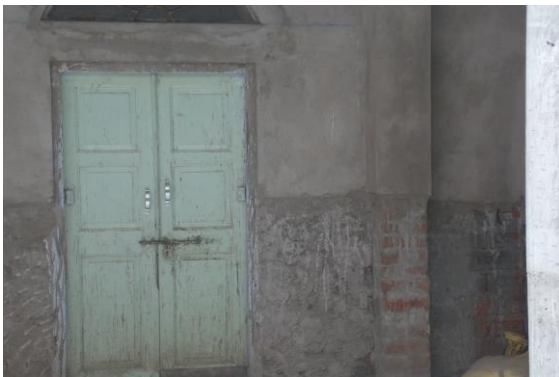
Photo 73

Peeling of Plaster on All Walls of Open Sky of Ground Floor

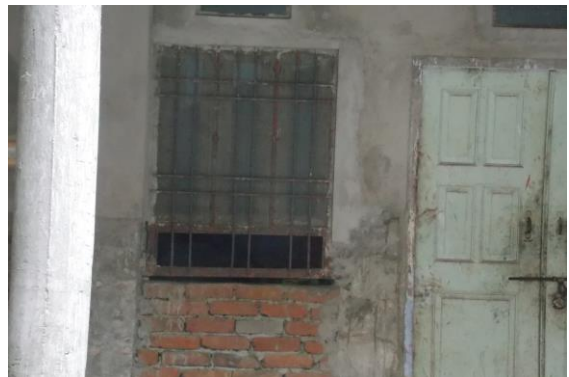
Photo 74

Peeling of Plaster on All Walls of Open Sky of Ground Floor

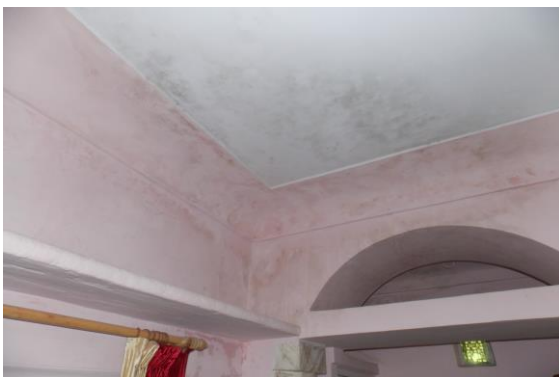
Photo 75

Dampness/Seepage on Wall No. 1, 4 & Roof of Hall No. 3 of First Floor

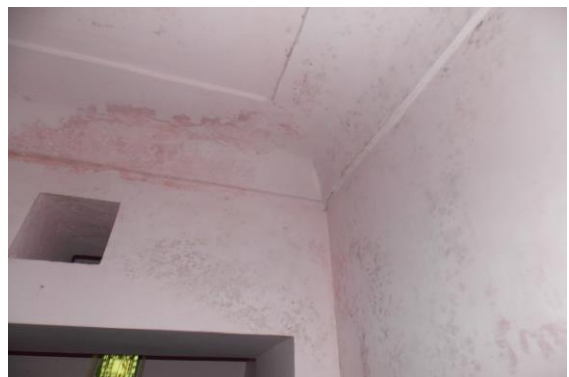
Photo 76

Dampness/Seepage on Wall No. 2, 3 & Roof of Room No. 4 of First Floor

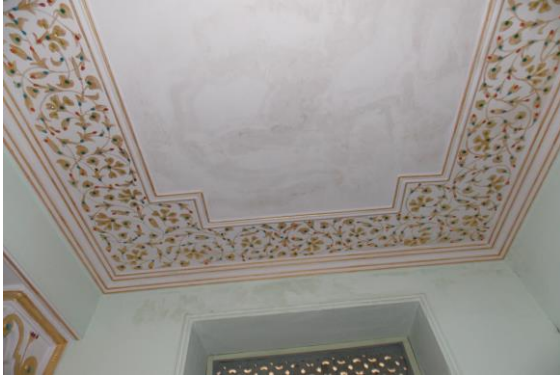
Photo 77

Dampness/Seepage on Wall No. 2 & Roof of Hall No. 5 of First Floor

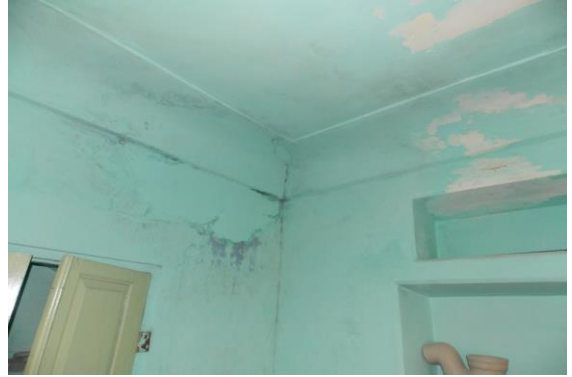
Photo 78

Dampness/Seepage on Wall No. 2, 4 & Roof of Room No. 1 of Second Floor

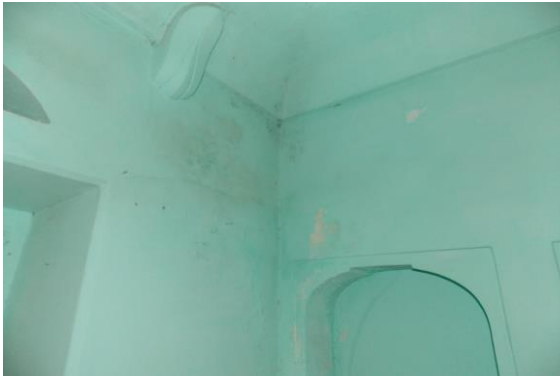
Photo 79

Dampness/Seepage on Wall No. 1, 3 & Roof of Room No. 1 of Second Floor

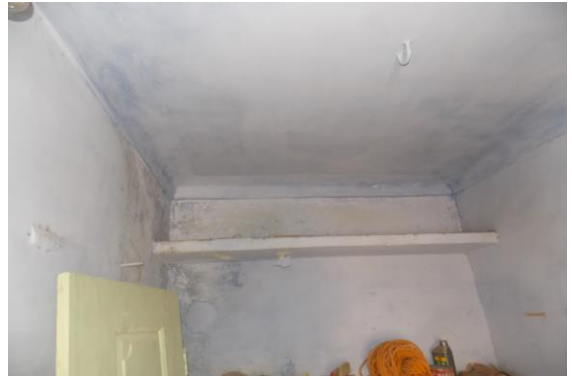
Photo 80

Dampness/Seepage on Wall No. 1, 2, 4 & Roof of Room No. 2 of Second Floor

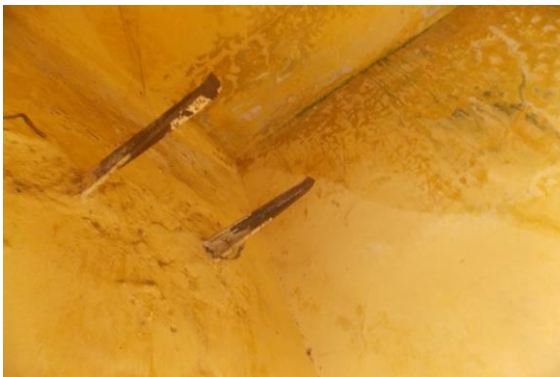
Photo 81

Dampness/Seepage on Wall No. 1, 4 & Roof of Toilet No. 1 of Second Floor

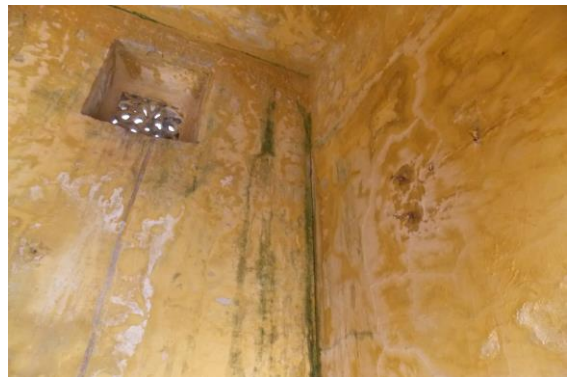
Photo 82

Dampness/Seepage on Wall No. 2, 4 & Roof of Bathroom of Second Floor

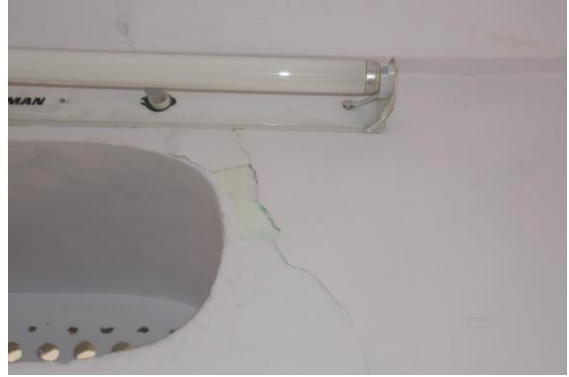
Photo 84  
Peeling of Plaster on Wall No. 3 of Hall No. 3 of Second Floor

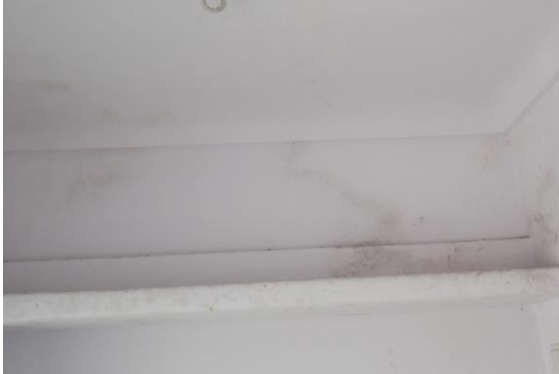
Photo 85  
Dampness/Seepage on Wall No. 2, 4 & Roof of Room No. 4 of Second Floor

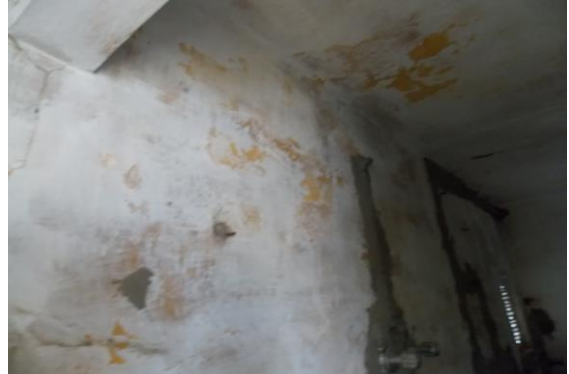
Photo 86  
Dampness/Seepage on Wall No. 4 & Roof of Toilet No. Toilet & Bathroom No.3 of Second Floor

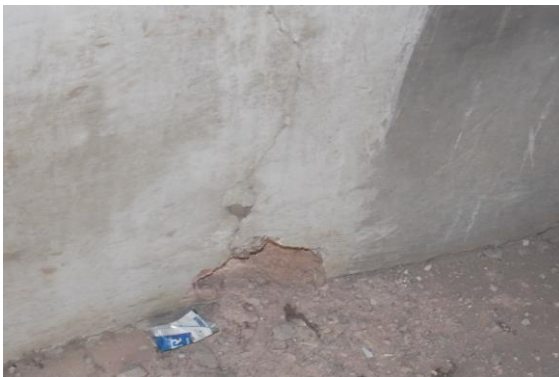
Photo 87  
Damaged Portion on Wall No. 4 of Toilet & Bathroom No.3 of Second Floor

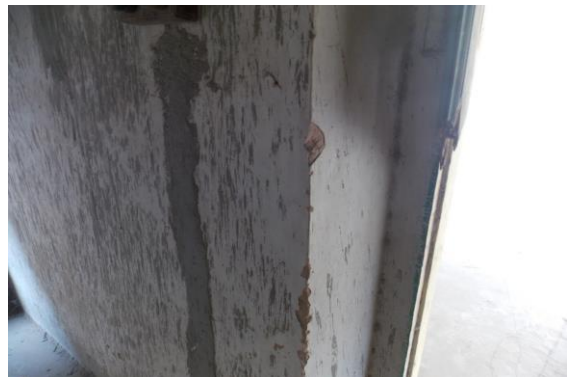
Photo 88  
Peeling of Plaster on Wall No. 3 of Room No. 3 of Second Floor

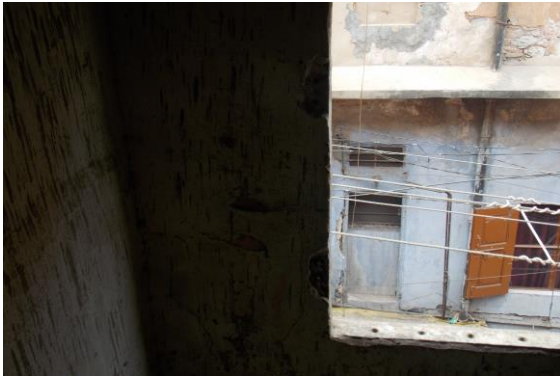
Photo 89

Peeling of Plaster on Wall No. 2 of Room No. 3 of Second Floor

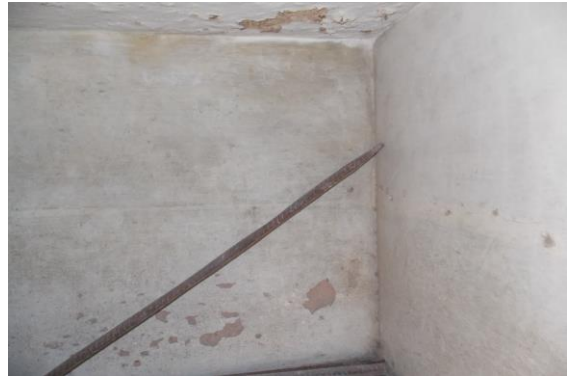
Photo 90

Peeling of Plaster on Wall No. 1 of Room No. 3 of Second Floor

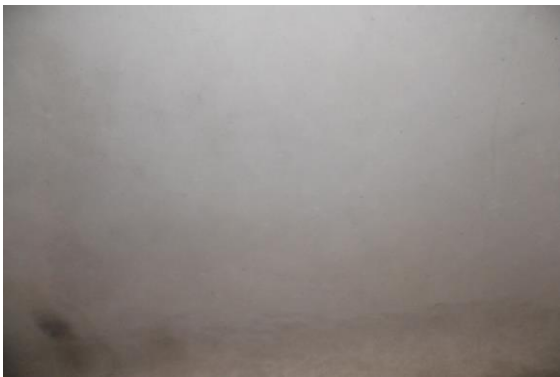
Photo 91

Peeling of Plaster on Roof of Room No. 3 of Second Floor

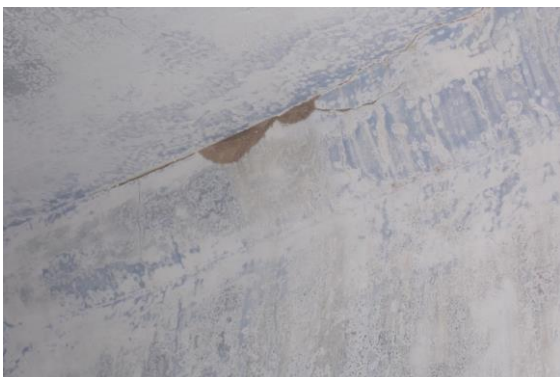
Photo 93

Peeling of Plaster on Wall No. 2 of Room No. 2 of Second Floor

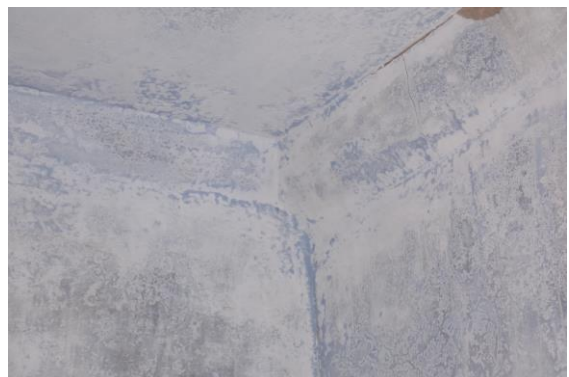
Photo 94

Dampness/Seepage on Wall No. 2, 4 & Roof of Room No. 2 of Second Floor

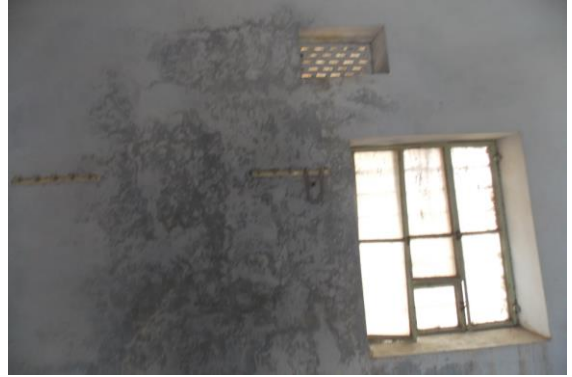
Photo 96

Dampness/Seepage on Wall No. 4 of Room No. 3 of Second Floor

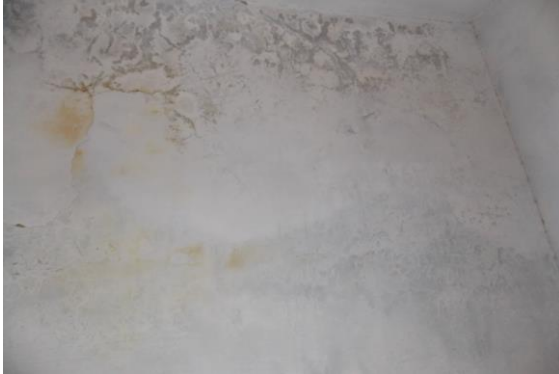
Photo 97

Dampness/Seepage on Wall No. 5 of Room No. 3 of Second Floor

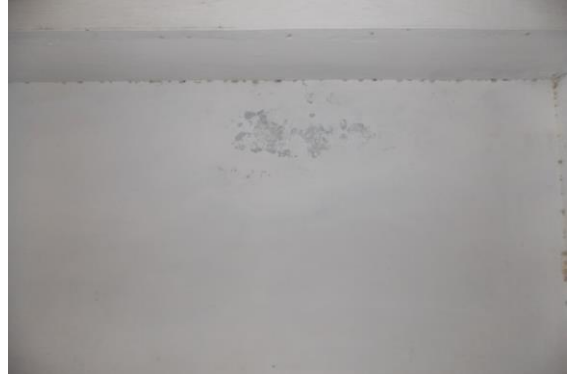
Photo 98

Dampness/Seepage on Wall No. 6 of Room No. 3 of Second Floor

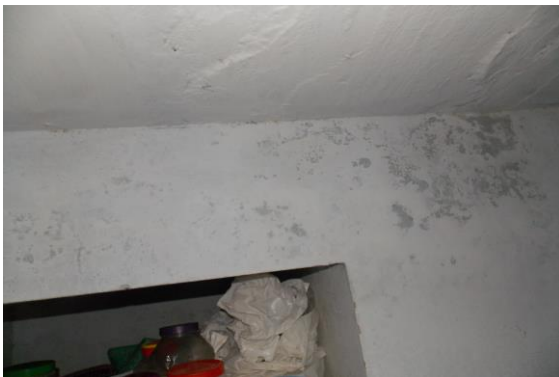
Photo 99

Dampness/Seepage on Wall No. 4 of Store of Second Floor

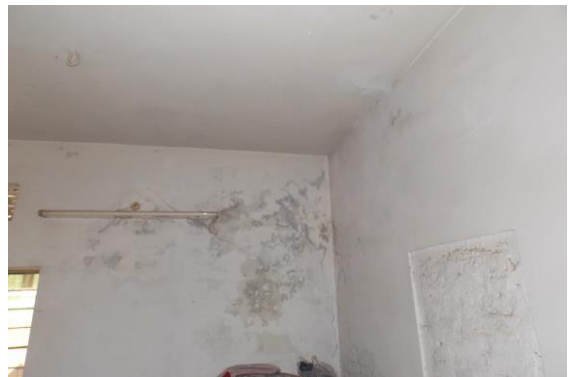
Photo 100

Dampness/Seepage on Wall No. 2 & 4 of Room No. 5 of Second Floor

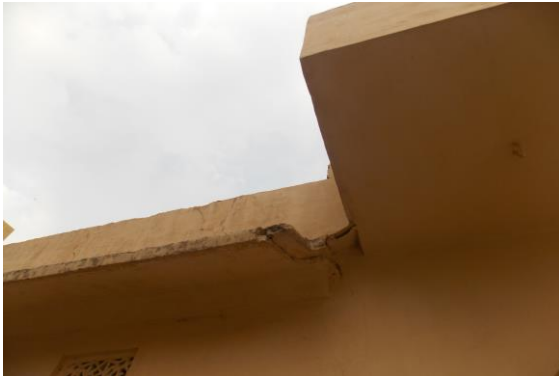
Photo 101

Peeling of Plaster on Roof of Part A of H. No.2193 of First Floor

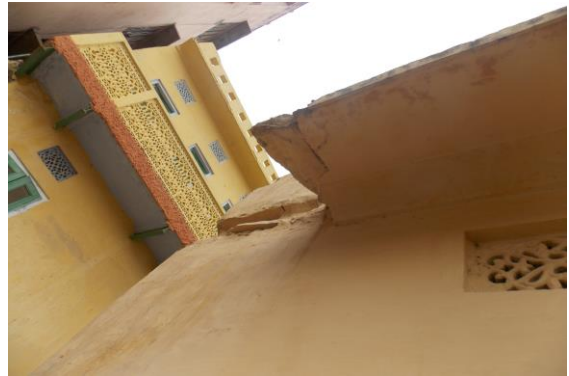
Photo 102

Peeling of Plaster on Roof of Part A of H. No.2193 of First Floor

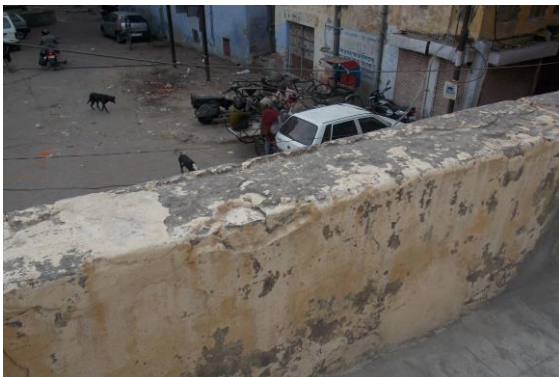
Photo 103

Peeling of Plaster on Perapet Wall of Part A of H. No.2193 of First Floor

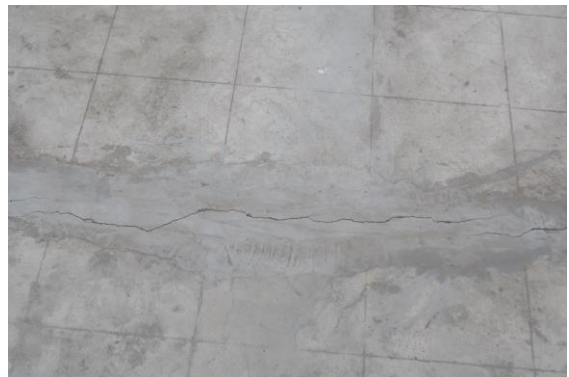
Photo 104

Peeling of Plaster on of Part A of H. No.2193 of First Floor

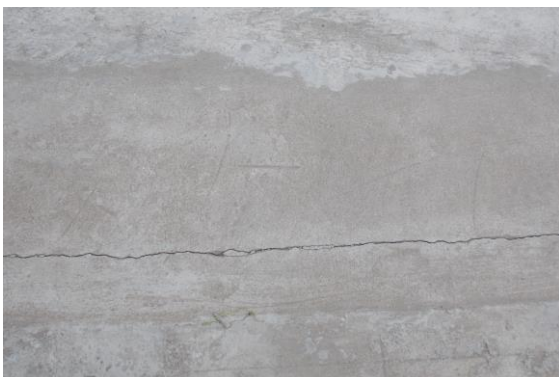
Photo 105

Peeling of Plaster on of Part A of H. No.2193 of First Floor

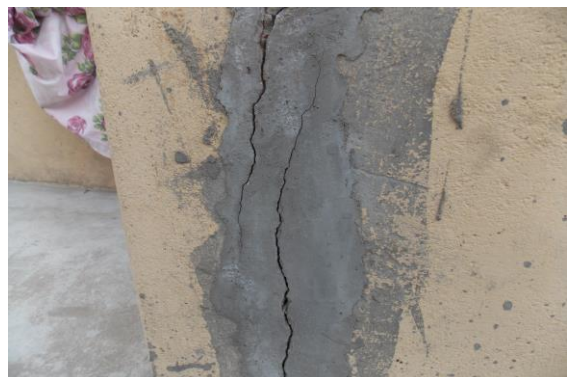
Photo 106

Peeling of Plaster on of Part A of H. No.2193 of First Floor

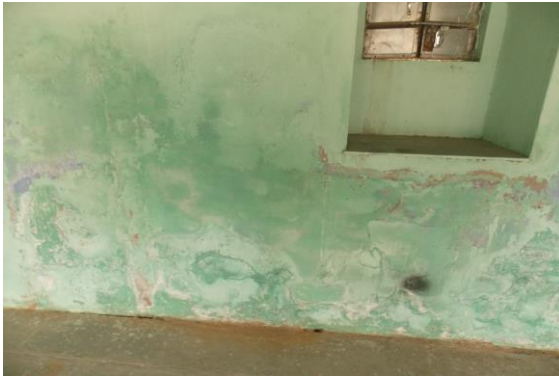
Photo 107  
Dampness/Seepage on Wall No. 4 of Gallery of Ground Floor

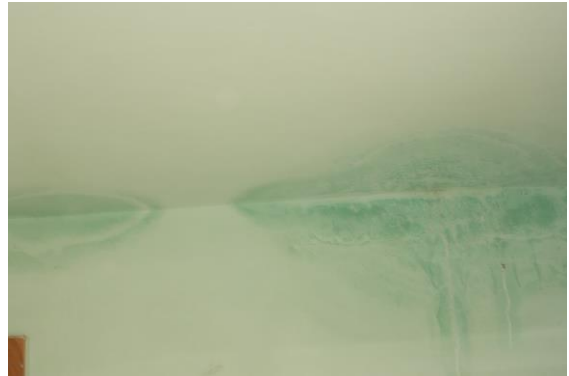
Photo 108  
Dampness/Seepage on Wall No. 2 & Roof of Gallery of Ground Floor

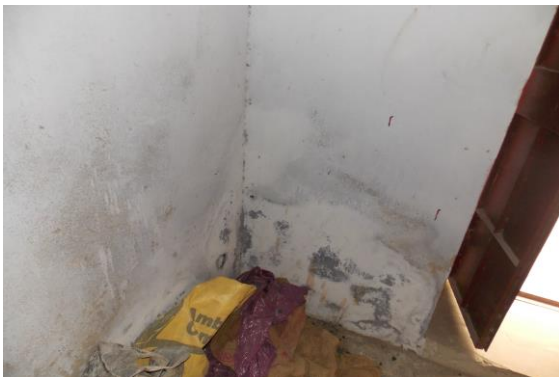
Photo 109  
Dampness/Seepage on Wall No. 4 & 5 of Passage of Ground Floor

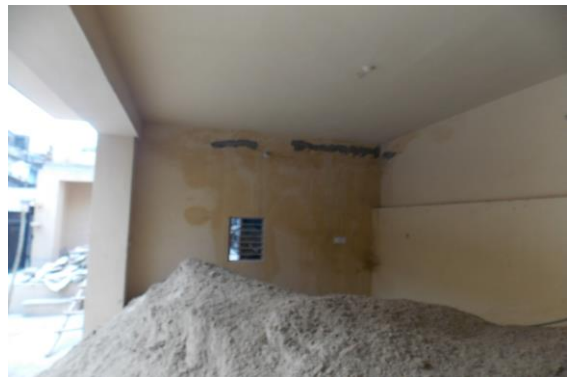
Photo 110  
Dampness/Seepage on Wall No. 1 of Lobby of Ground Floor

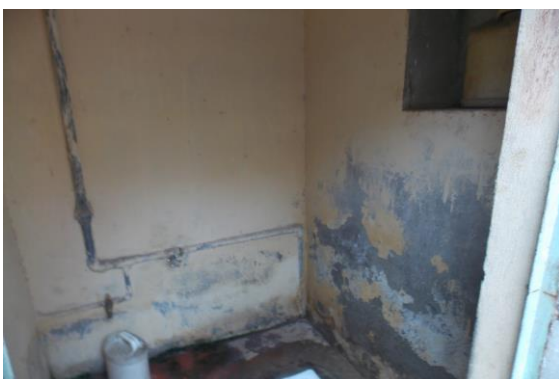
Photo 111  
Dampness/Seepage on Wall No. 2 & 4 of Toilet No. 1 of Ground Floor

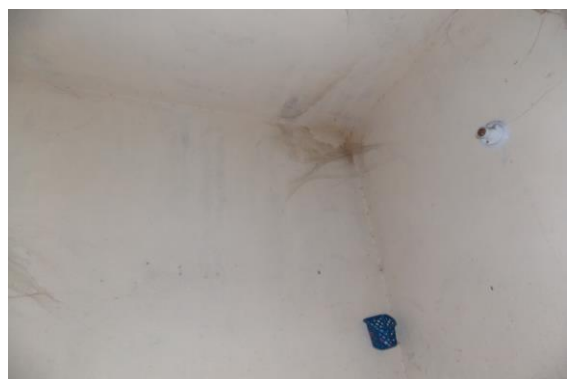
Photo 112  
Dampness/Seepage on Wall No. 4 & Roof of Bathroom of Ground Floor

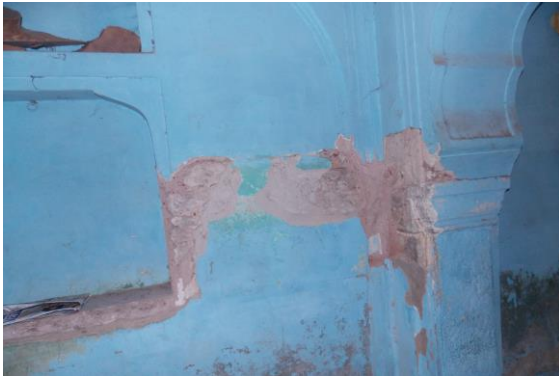
Photo 113  
Peeling of Plaster on Wall No. 1 of Hall No. 1 of Ground Floor

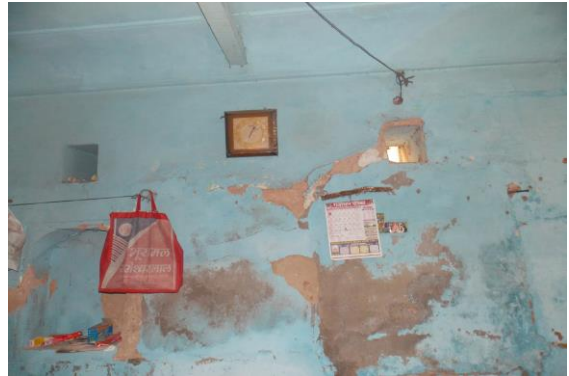
Photo 114  
Peeling of Plaster on Wall No. 4 of Hall No. 1 of Ground Floor

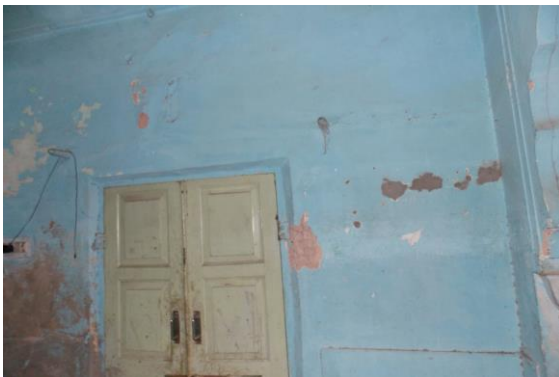
Photo 115  
Peeling of Plaster on Wall No. 2 of Hall No. 1 of Ground Floor

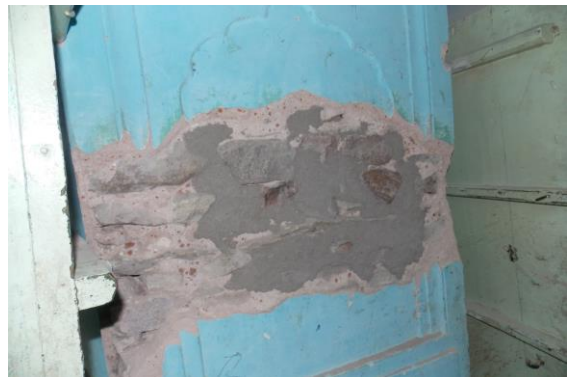
Photo 116  
Peeling of Plaster on Wall No. 3 of Hall No. 1 of Ground Floor

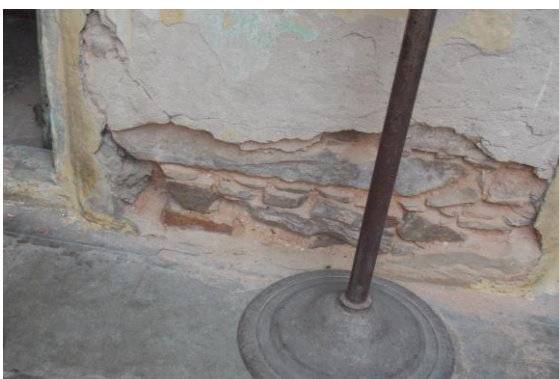
Photo 117  
Peeling of Plaster on Wall No. 2 of Open Sky No.2 of Ground Floor

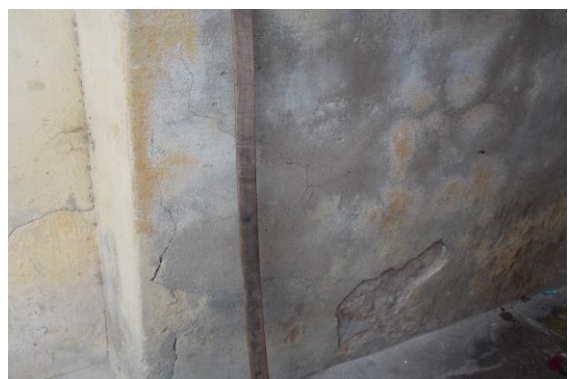
Photo 118  
Peeling of Plaster on Wall No. 4 of Open Sky No.2 of Ground Floor

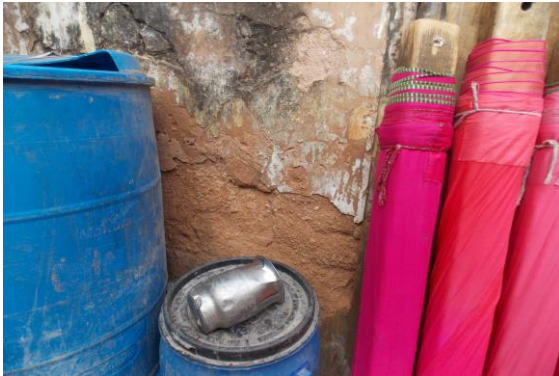
Photo 119

Peeling of Plaster on Wall No. 4 of Open Sky No.2 of Ground Floor

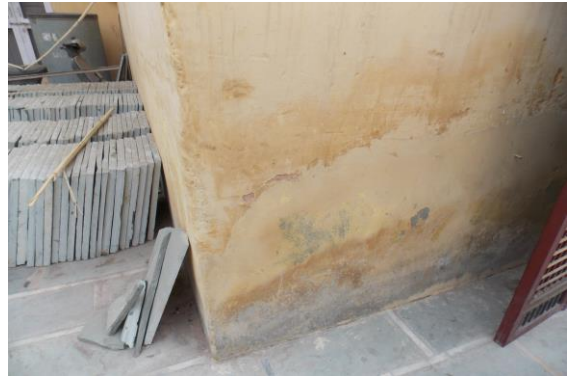
Photo 120

Dampness/Seepage on All Walls of Open Sky No.1 of Ground Floor

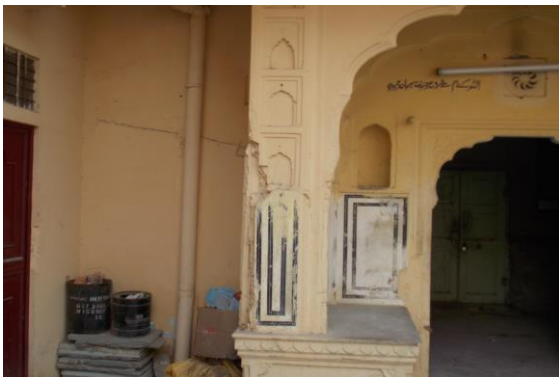
Photo 121

Peeling of Plaster on Outer Wall of External Façade of Part B of House No.2193, Ground Floor

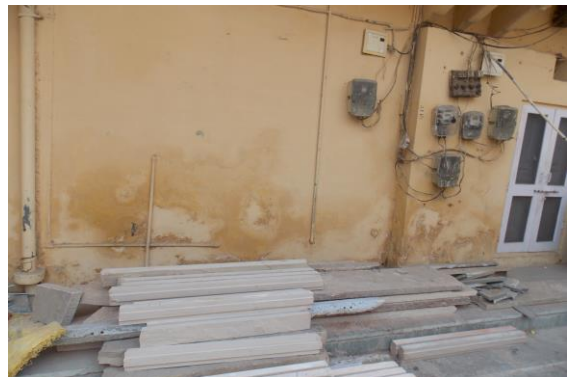
Photo 122

Dampness/Seepage on Outer Wall of External Façade of Part B of House No.2193, Ground Floor

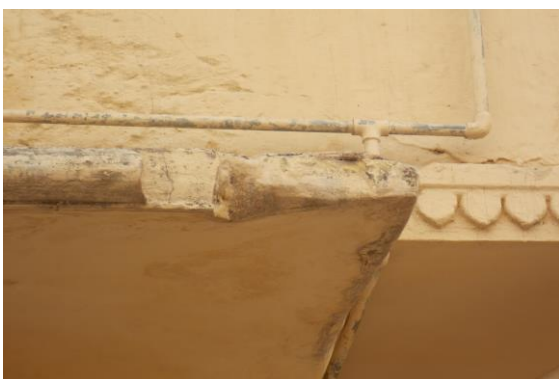
Photo 123

Damaged Portion on Shade of External Façade of Part B of House No.2193, Ground Floor

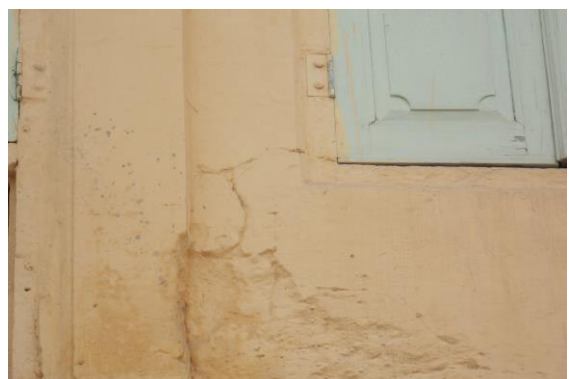
Photo 124

Peeling of Plaster on Outer Wall of External Façade of Part B of House No.2193, Ground Floor

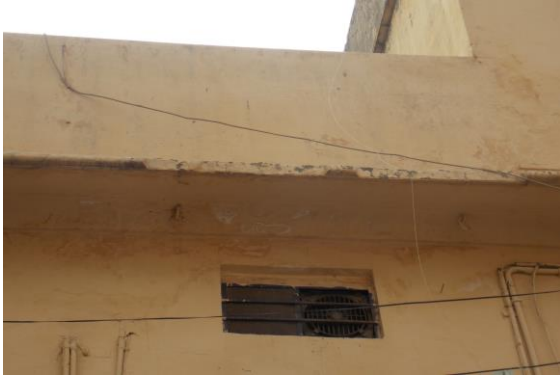
Photo 125

Damaged Portion on Shade of External Façade of Part B of House No.2193, First Floor

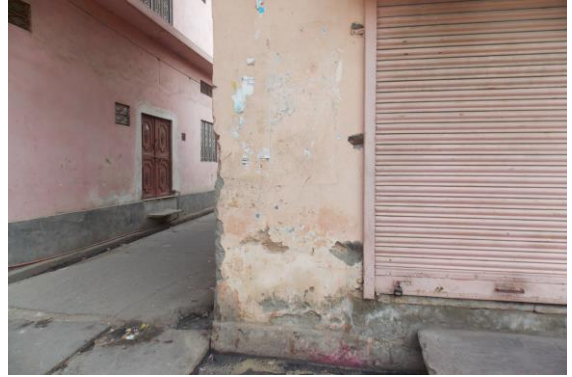
Photo 126

Peeling of Plaster on Outer Wall of External Façade of Part A of House No.2193, Ground Floor

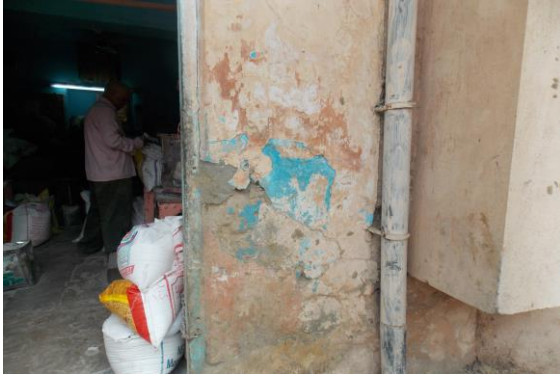
Photo 127

Peeling of Plaster on Outer Wall of External Façade of Part A of House No.2193, Ground Floor

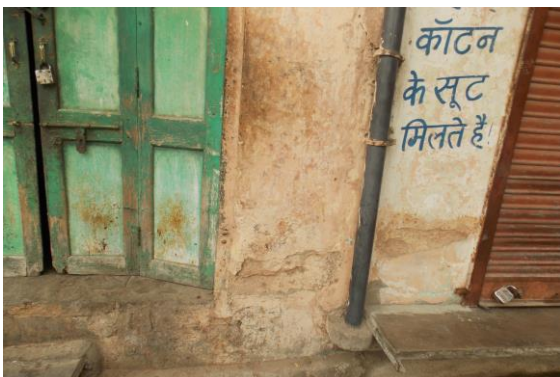
Photo 128

Peeling of Plaster on Outer Wall of External Façade of Part A of House No.2193, Ground Floor

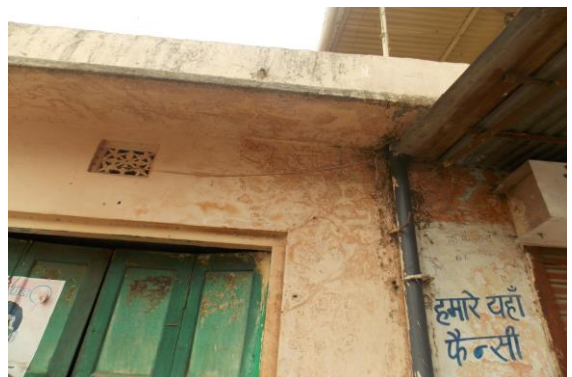
Photo 129

Peeling of Plaster on Outer Wall of External Façade of Part A of House No.2193, Ground Floor

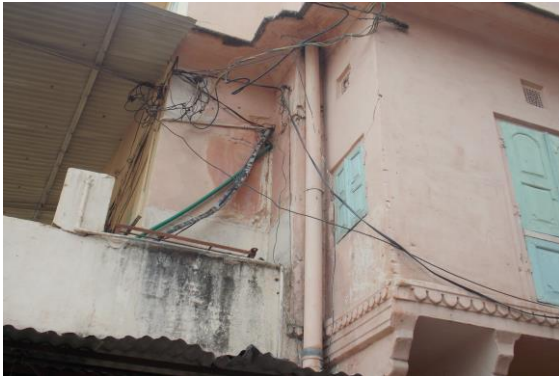
Photo 130

Dampness/Seepage on Outer Wall of External Façade of Part A of House No.2193, Ground Floor

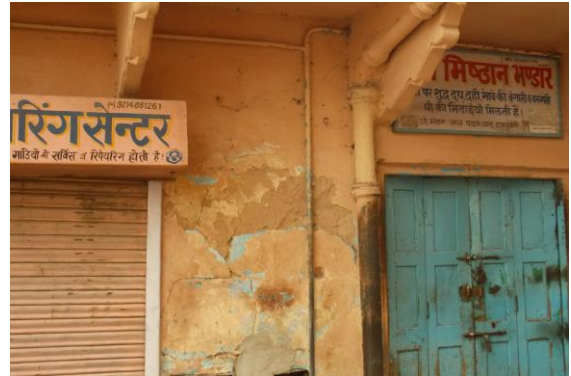
Photo 131

Dampness/Seepage on Outer Wall of External Façade of Part B of House No.2193, First Floor

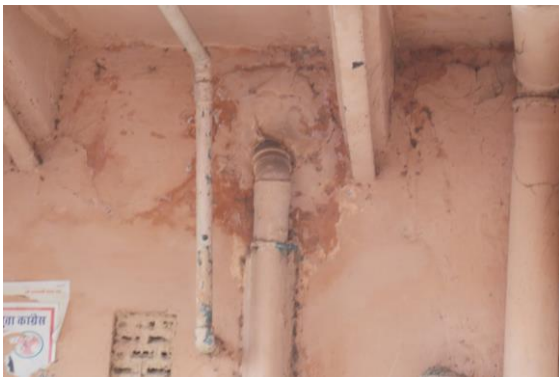
Photo 132

Peeling of Plaster on Outer Wall of External Façade of Part B of House No.2193, Ground Floor

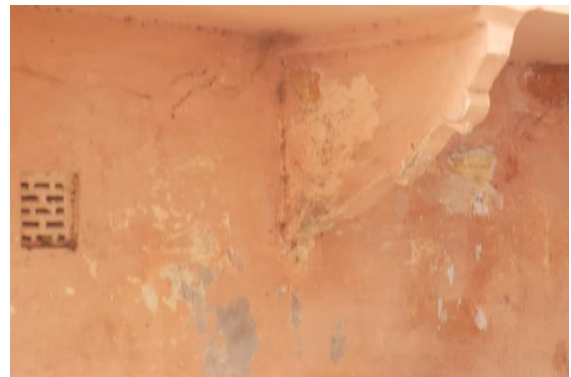
Photo 133

Dampness/Seepage on Outer Wall of External Façade of Part B of House No.2193, Ground Floor

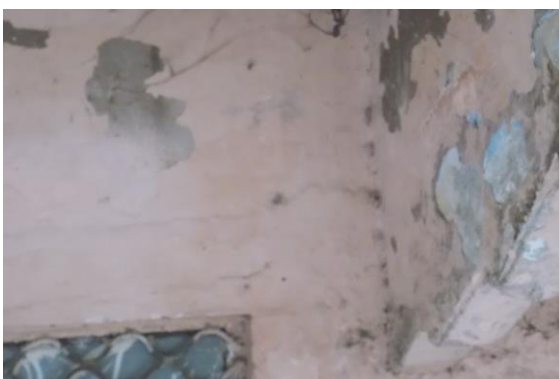
Photo 134

Dampness/Seepage on Outer Wall of External Façade of Part B of House No.2193, Ground Floor

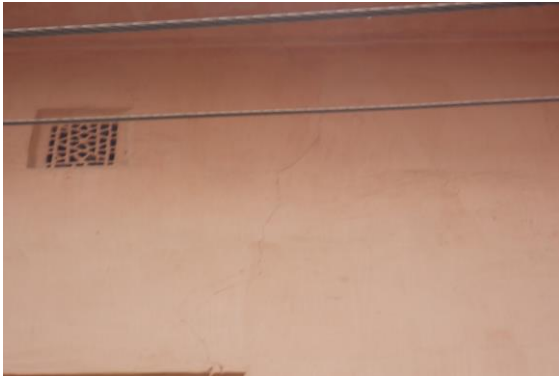
Damaged Portion on Shade of External Façade of Part B of House No.2193, Second Floor

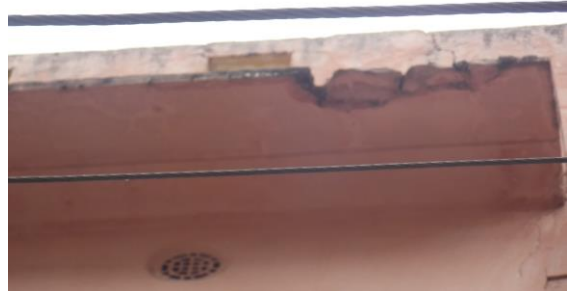
Photo 137

Plaster Crack on Outer Wall of External Façade of Part B of House No.2193, Second Floor

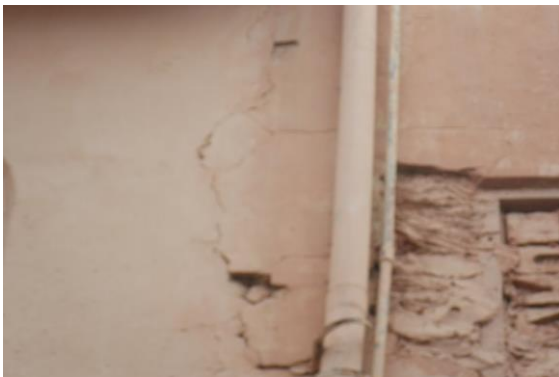
Photo 138

Damaged Portion on Outer Wall of External Façade of Part B of House No.2193, Second Floor

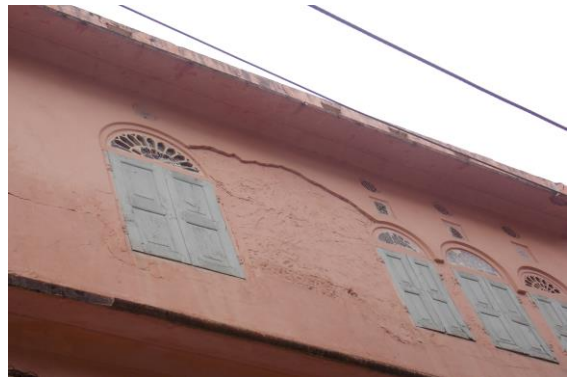
Photo 139

Peeling of Plaster on Outer Wall of External Façade of Part B of House No.2193, Second Floor

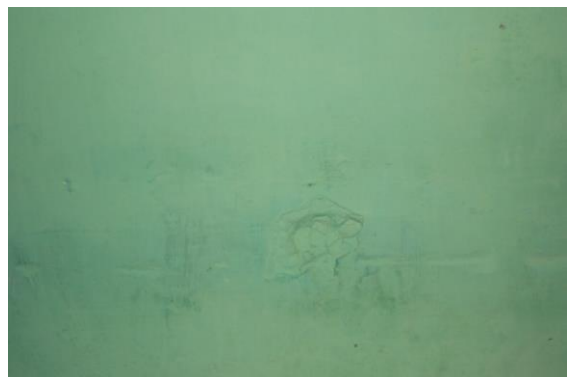
Photo 141

Peeling of Plaster on Wall No. 4 of Shop Jain Mishtan Bhandar of Ground Floor

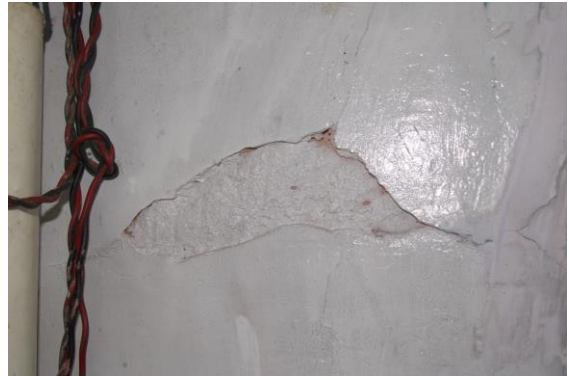
Photo 143

Peeling of Plaster on Floor of Shop Dilip Repairing Center of Ground Floor

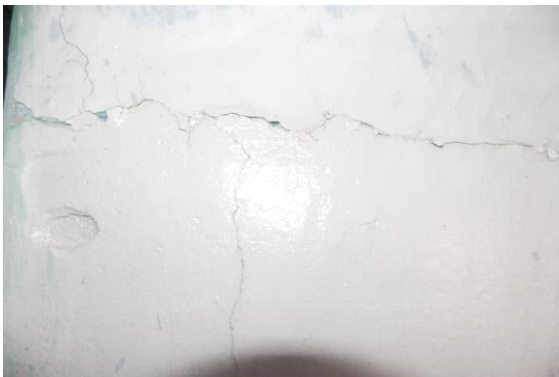
Photo 144

Peeling of Plaster on Wall No. 1 of Shop Dilip Repairing Center of Ground Floor

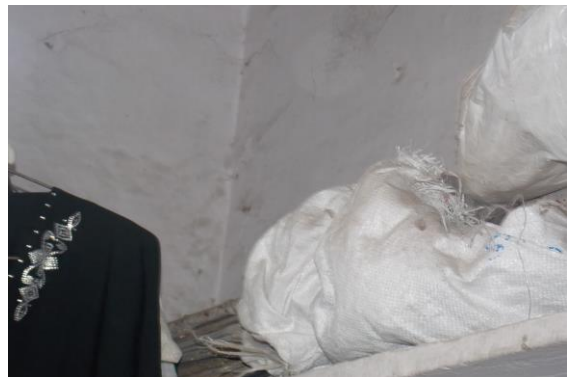
Photo 145

Peeling of Plaster on Wall No. 2 of Shop Dilip Repairing Center of Ground Floor

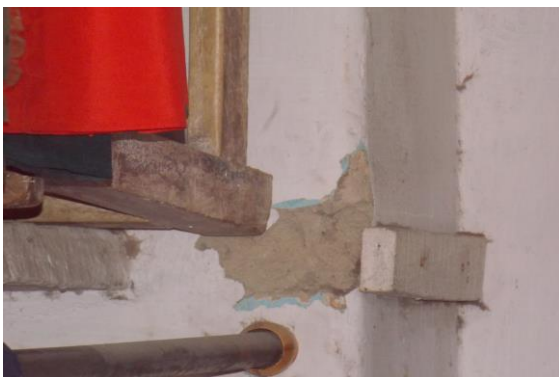
Photo 146

Dampness/Seepage on Wall No. 2 & 4 of Shop Rehan Textile of Ground Floor
