### Pre Building Condition Survey Report

Name and Address of Structure :	Badi Chopar to Ramp Area (UP Line)
---------------------------------	------------------------------------

Name of the Project	<b>Contract JMRC-UG1B</b> “Design and Construction of Tunnel between Chandpole and Badi Chouper and reverse line by Shield TBM, Underground Metro Stations at Choti Chouper and Badi Chouper by Cut and Cover Methods on East West Corridor of Jaipur Metro Rail Corporation Limited .”	
Owner :

Pre Building Condition Survey Report Badi Chopar to Ramp Area (UP Line)

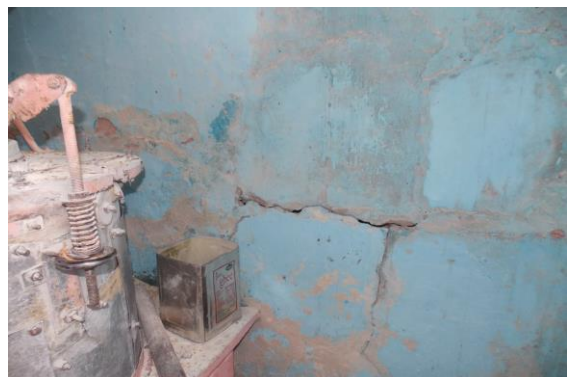
Photo 147

Peeling of Plaster on Wall No. 4 of Shop Rehan Textile of Ground Floor

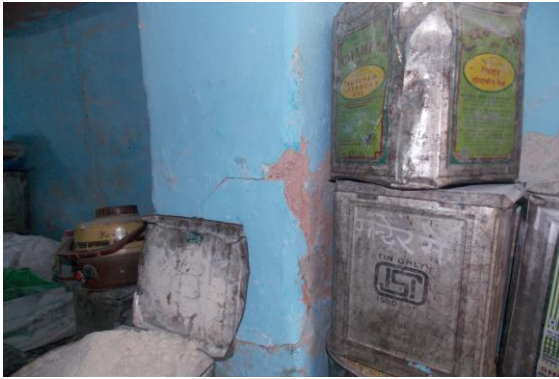
Photo 148

Damaged Portion on Wall No. 2 of Shop Jai Hind Floor Mills of Ground Floor

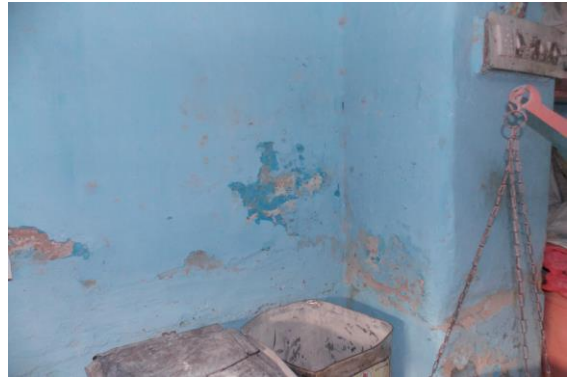
Photo 149

Peeling of Plaster on Wall No. 2 of Shop Jai Hind Floor Mills of Ground Floor

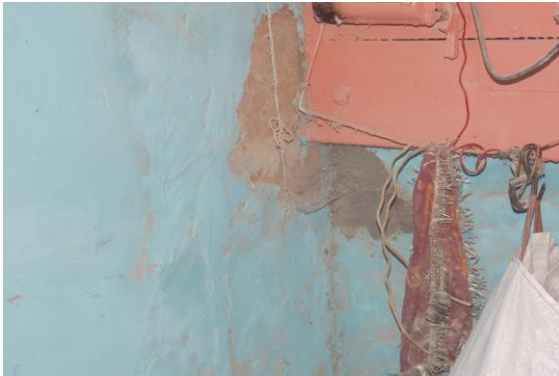
Photo 150

Peeling of Plaster on Wall No. 1 of Shop Jai Hind Floor Mills of Ground Floor

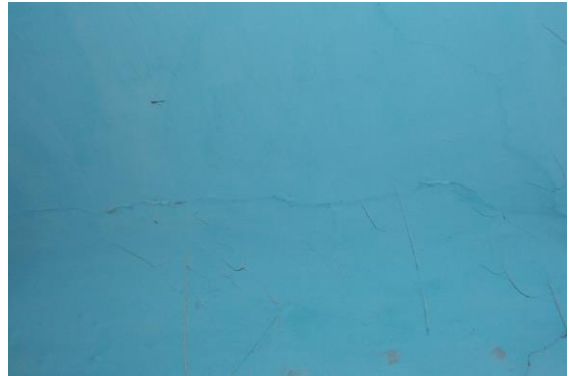
Photo 151

Peeling of Plaster on Wall No. 1 & 4 of Shop Jai Hind Floor Mills of Ground Floor

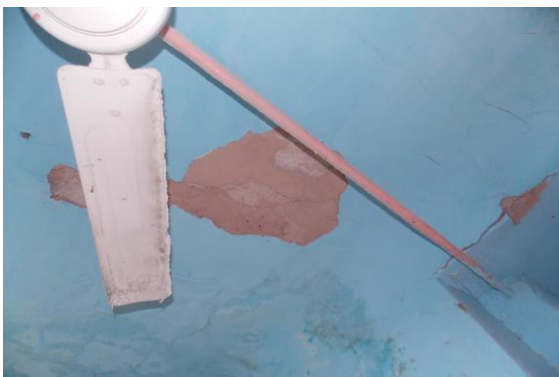
Photo 152

Peeling of Plaster on Roof of Shop Jai Hind Floor Mills of Ground Floor

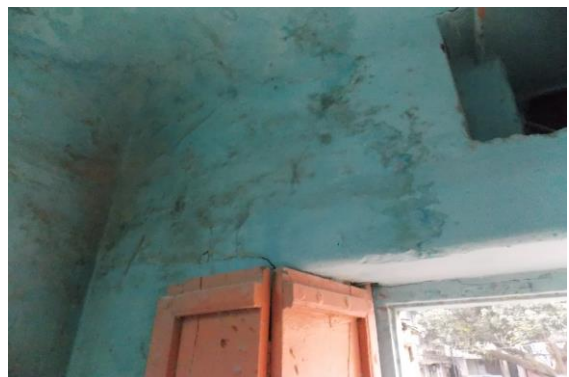
Photo 153

Peeling of Plaster on Roof of Shop Jai Hind Floor Mills of Ground Floor

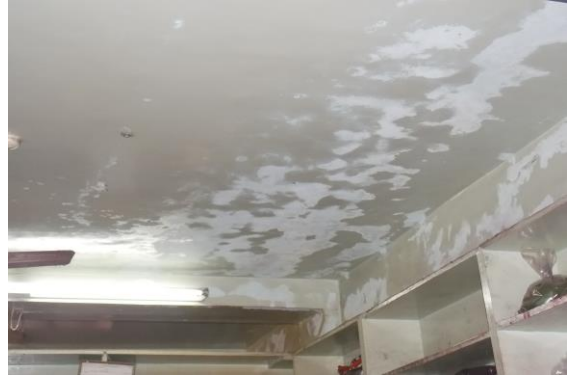
Photo 155

Dampness/Seepage on Wall No. 3 of Shop Jai Hind Floor Mills of Ground Floor

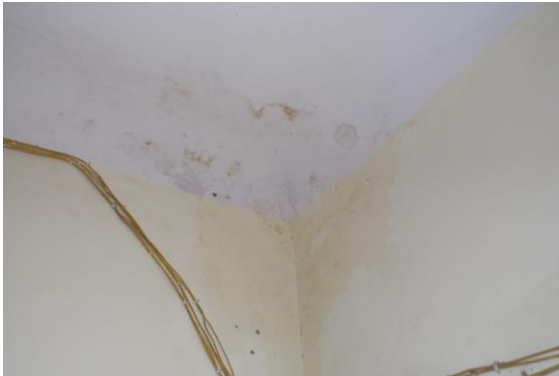
Photo 156

Dampness/Seepage on Roof & Wall No. 2 of Shop Babu Bhai Pan Bhandar of Ground Floor

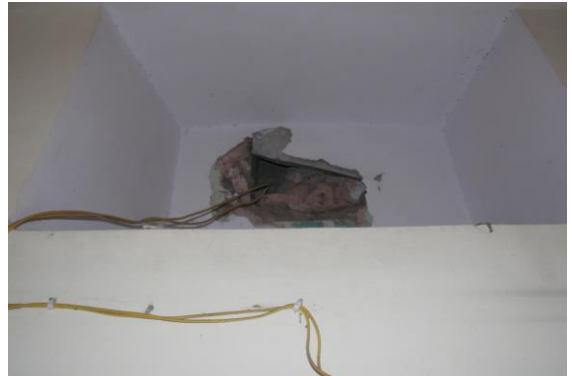
Photo 157

Dampness/Seepage on Wall No. 3, 2 & Roof of Shop Babu Bhai Pan Bhandar of Ground Floor

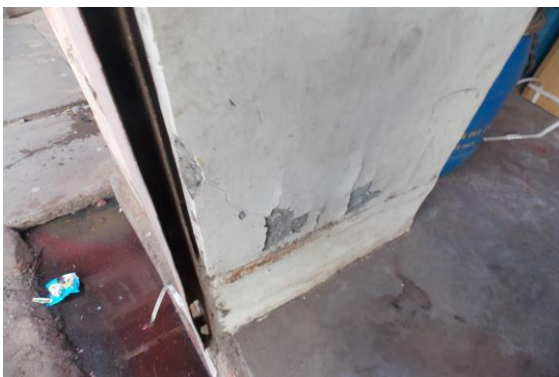
Photo 158

Damaged Portion on Wall No. 3 of Shop Babu Bhai Pan Bhandar of Ground Floor

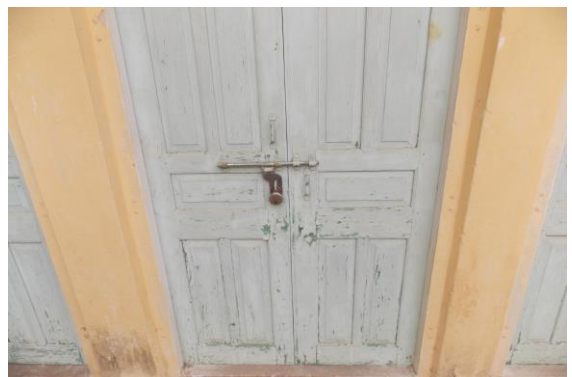
Photo 159

Peeling of Plaster on Wall No. 1 of Shop Babu Bhai Pan Bhandar of Ground Floor

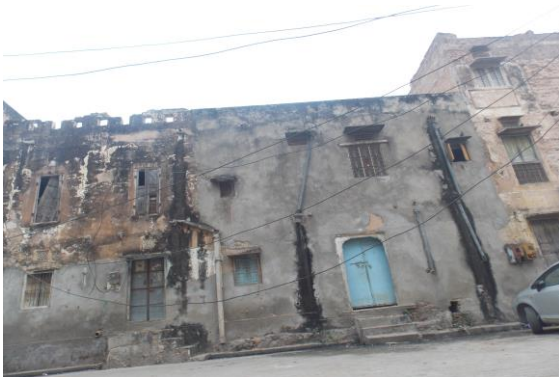
Photo 3  
Back Side View of House No. 2198, House No. 2198, Ground Floor

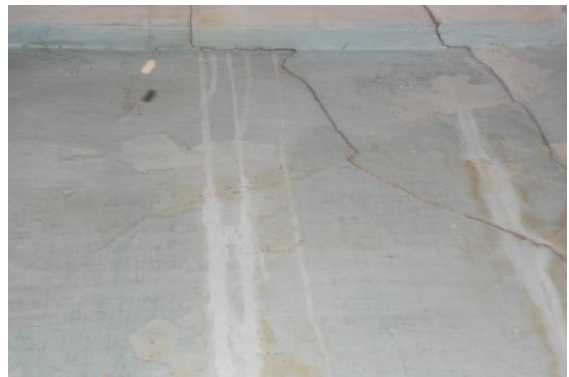
Photo 4  
Inclined Crack on Wall No. 1 of Toilet No. 3, House No. 2198, First Floor  
Approx. Width = 1.5mm, Approx. Length = 0.8m. Distance from Wall No. 4 = 0.03m, Height from Floor = 2.3m.

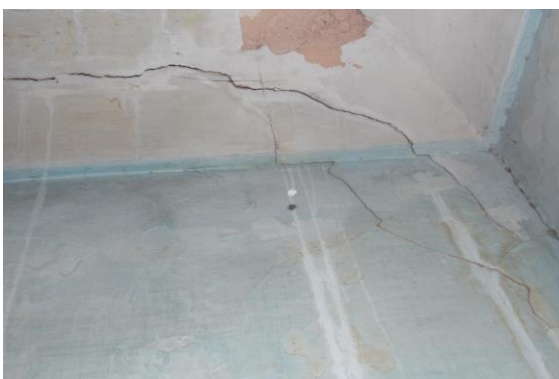
Photo 5  
Inclined Crack on Wall No. Roof & 1 of Toilet No. 3, House No. 2198, First Floor  
Approx. Width = 2.5mm, Approx. Length = 3m. Distance from Wall No. 4 = 0.05m, Height from Floor = 2.4m.

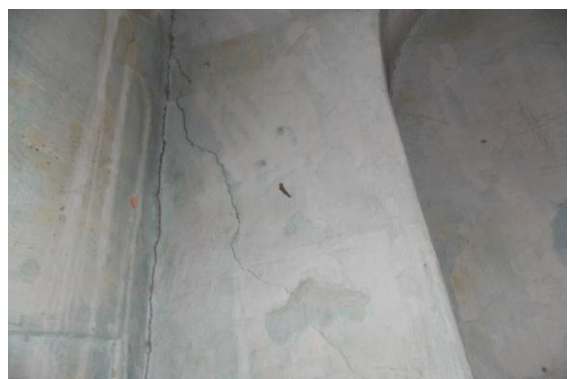
Photo 6  
Inclined Crack on Wall No. 4 of Toilet No. 3, House No. 2198, First Floor  
Approx. Width = 1mm, Approx. Length = 1.2m. Distance from Wall No. 1 = 0.25m, Height from Floor = 1.6m.

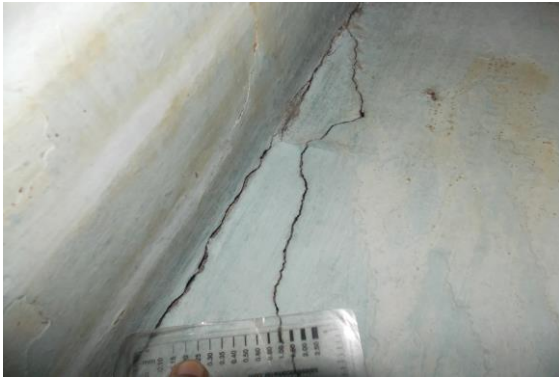
Photo 7

Inclined Crack on Wall No. 4 of Toilet No. 3, House No. 2198, First Floor  
Approx. Width = 1mm, Approx. Length = 1.2m. Distance from Wall No. 1 = 0.25m, Height from Floor = 1.6m.

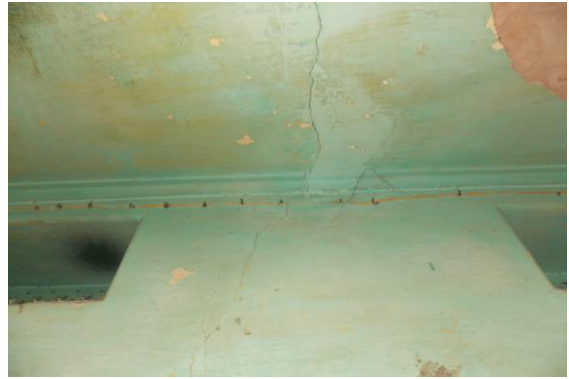
Photo 8

Inclined Crack on Wall No. 3 & Roof of Open Sky 2, House No. 2198, First Floor  
Approx. Width = 2mm, Approx. Length = 1.9m. Distance from Wall No. 1 = 1.8m, Height from Floor = 2m.

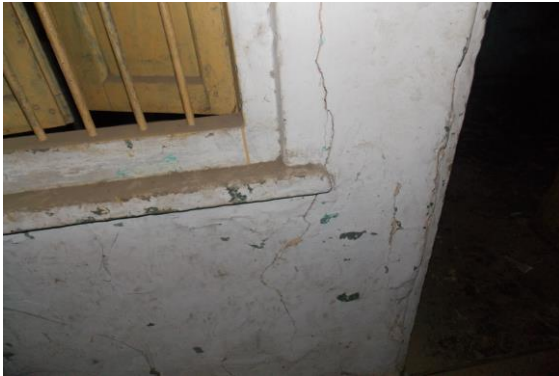
Photo 9

Inclined Crack on Wall No. 1 of Toilet No. 5, House No. 2198, First Floor  
Approx. Width = 2mm, Approx. Length = 1.5m. Distance from Wall No. 3 = 0.9m, Height from Floor = 0.1m.

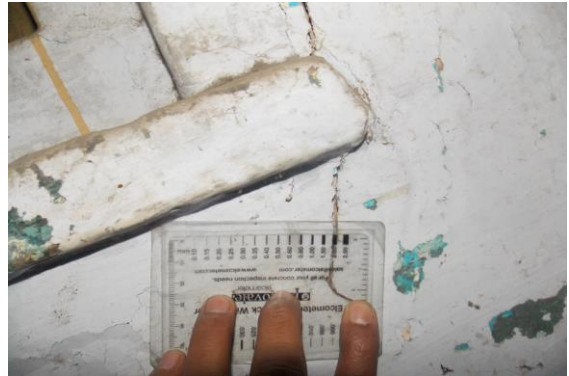
Photo 10

Inclined Crack on Wall No. 1 of Toilet No. 5, House No. 2198, First Floor  
Approx. Width = 2mm, Approx. Length = 1.5m. Distance from Wall No. 3 = 0.9m, Height from Floor = 0.1m.

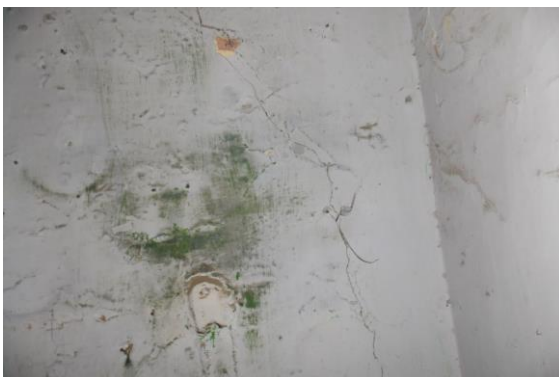
Photo 11

Inclined Crack on Wall No. 1 of Toilet No. 4, House No. 2198, First Floor  
Approx. Width = 0.8mm, Approx. Length = 2.5m. Distance from Wall No. 4 = 0m, Height from Floor = 0.6m.

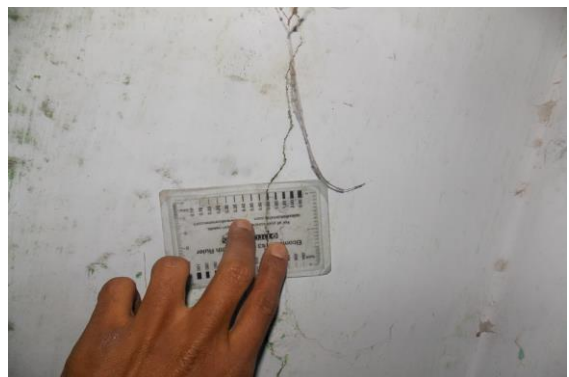
Photo 12

Inclined Crack on Wall No. 1 of Toilet No. 4, House No. 2198, First Floor  
Approx. Width = 0.8mm, Approx. Length = 2.5m. Distance from Wall No. 4 = 0m, Height from Floor = 0.6m.

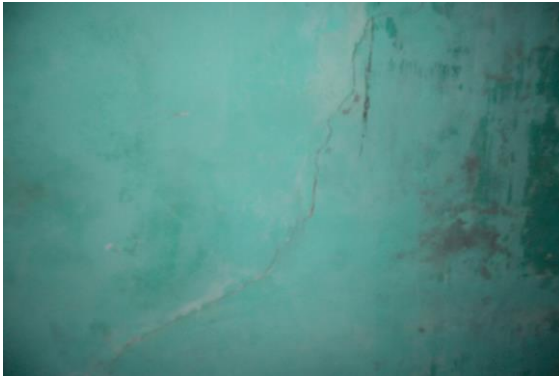
Photo 13

Inclined Crack on Wall No. 4 of Toilet No. 10, House No. 2198, First Floor Approx. Width = 1mm, Approx. Length = 3.5m. Distance from Wall No. 1 = 2.6m, Height from Floor = 0m.

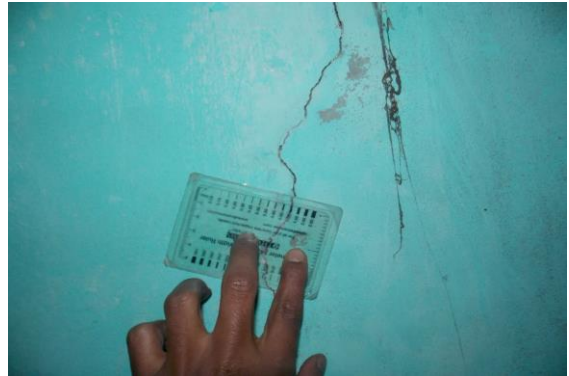
Photo 14

Inclined Crack on Wall No. 4 of Toilet No. 10, House No. 2198, First Floor Approx. Width = 1mm, Approx. Length = 3.5m. Distance from Wall No. 1 = 2.6m, Height from Floor = 0m.

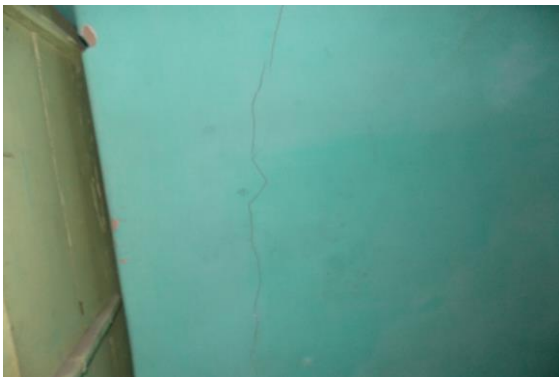
Photo 15

Inclined Crack on Wall No. 3 of Toilet No. 10, House No. 2198, First Floor Approx. Width = 1mm, Approx. Length = 2m. Distance from Wall No. 1 = 2m, Height from Floor = 0.4m.

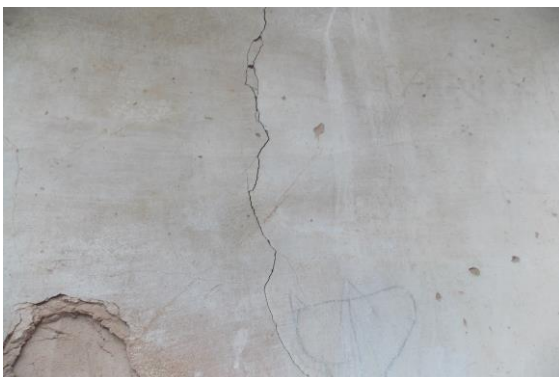
Photo 17

Inclined Crack on Wall No. 1 of Open Sky 1, House No. 2198, First Floor Approx. Width = 1.5mm, Approx. Length = 3.5m. Distance from Wall No. 3 = 2.1m, Height from Floor = 0m.

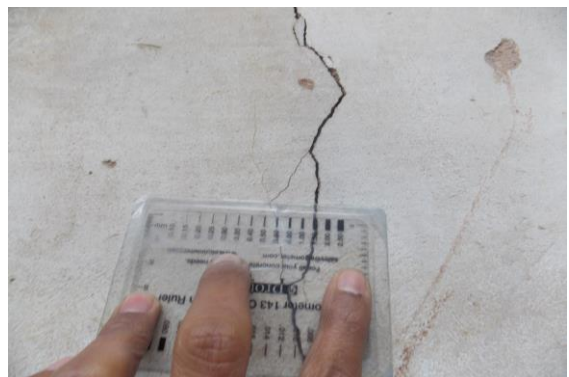
Photo 18

Inclined Crack on Wall No. 1 of Open Sky 1, House No. 2198, First Floor Approx. Width = 1.5mm, Approx. Length = 3.5m. Distance from Wall No. 3 = 2.1m, Height from Floor = 0m.

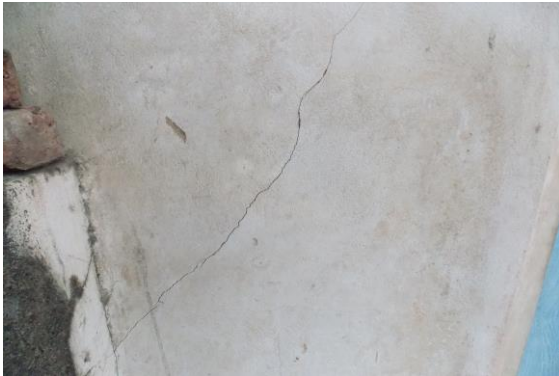
Photo 19

Inclined Crack on Wall No. 2 of Open Sky 1, House No. 2198, First Floor Approx. Width = 0.8mm, Approx. Length = 0.6m. Distance from Wall No. 4 = 0m, Height from Floor = 0.8m.

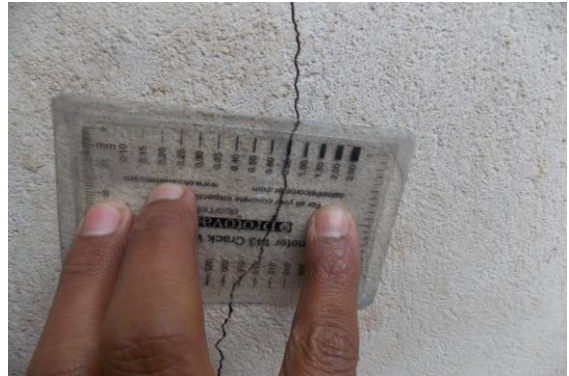
Photo 20

Inclined Crack on Wall No. 2 of Open Sky 1, House No. 2198, First Floor Approx. Width = 0.8mm, Approx. Length = 0.6m. Distance from Wall No. 4 = 0m, Height from Floor = 0.8m.

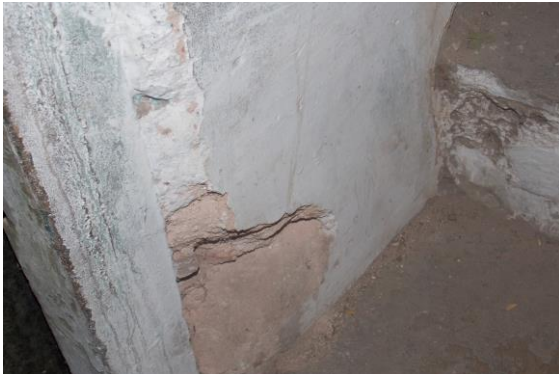
Photo 21

Peeling of Plaster on Wall No. 1 of Stair 1, Ground Floor to First Floor of House No. 2198, First Floor

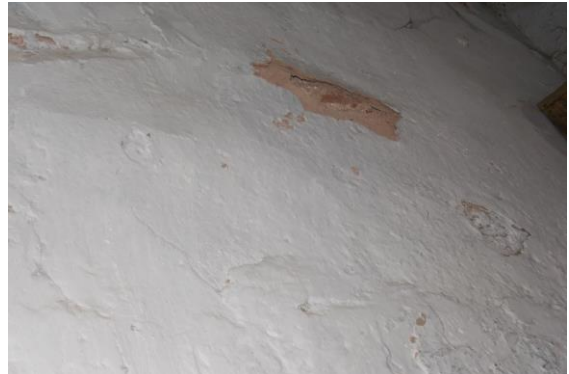
Photo 22

Peeling of Plaster on Wall No. 1 of Stair 1, Ground Floor to First Floor of House No. 2198, First Floor

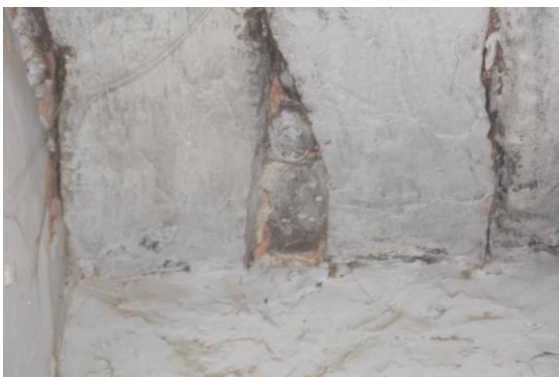
Photo 23

Peeling of Plaster on Roof of Stair 1, Ground Floor to First Floor of House No. 2198, First Floor

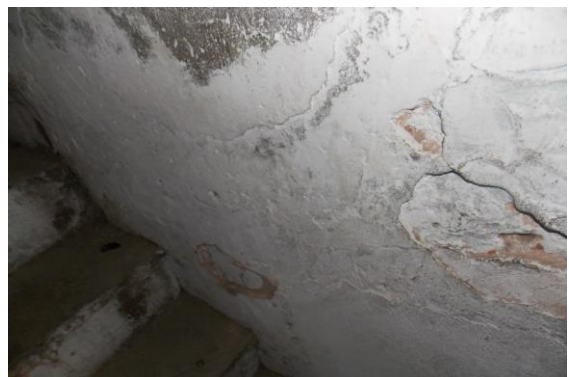
Photo 24

Peeling of Plaster on Wall No. 2 of Stair 1, Ground Floor to First Floor of House No. 2198, First Floor

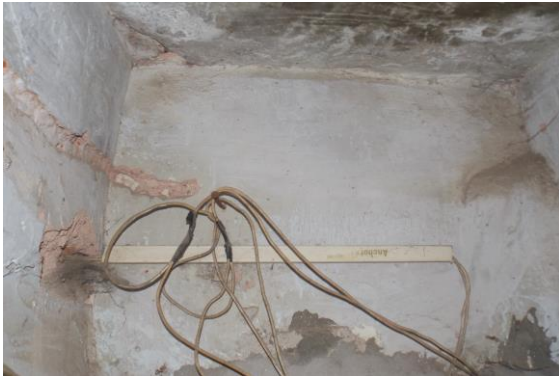
Photo 25

Peeling of Plaster on Wall No. 3 of Stair 1, Ground Floor to First Floor of House No. 2198, First Floor

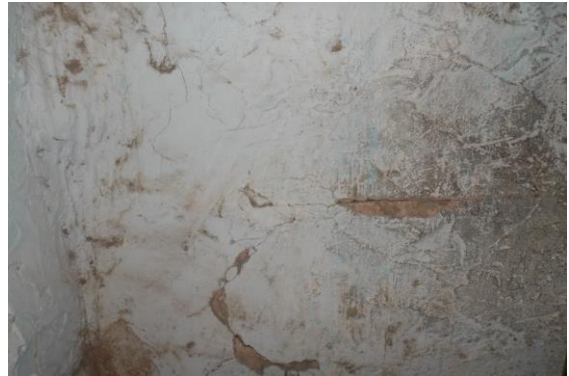
Photo 26

Peeling of Plaster on Wall No. 4 of Stair 1, Ground Floor to First Floor of House No. 2198, First Floor

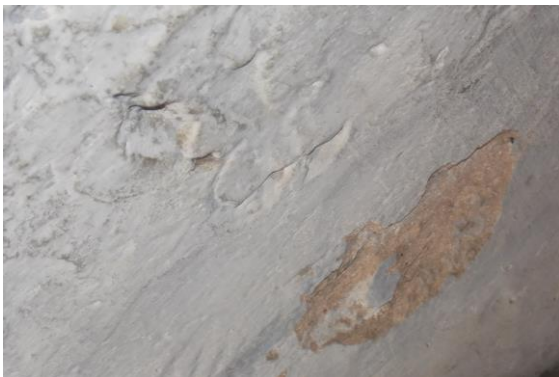
Photo 27

Peeling of Plaster on Wall No. 1 of Stair 1, Ground Floor to First Floor of House No. 2198, First Floor

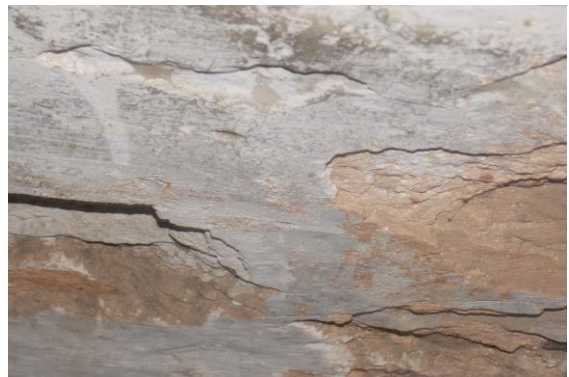
Photo 28

Peeling of Plaster on Wall No. 2 of Stair 1, Ground Floor to First Floor of House No. 2198, First Floor

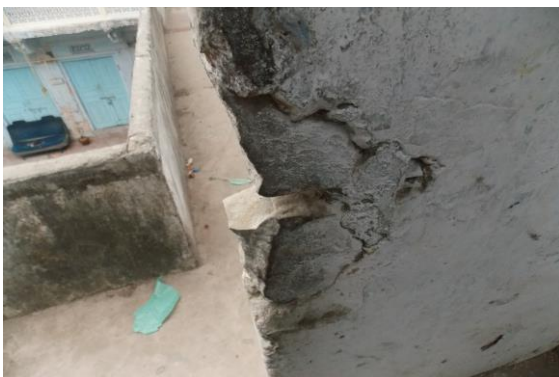
Photo 29

Peeling of Plaster on Wall No. 3 of Stair 1, Ground Floor to First Floor of House No. 2198, First Floor

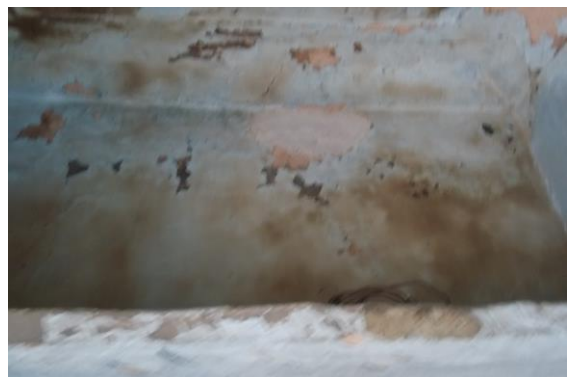
Photo 30

Peeling of Plaster on Wall No. 1 of Toilet No. 2 of House No. 2198, First Floor

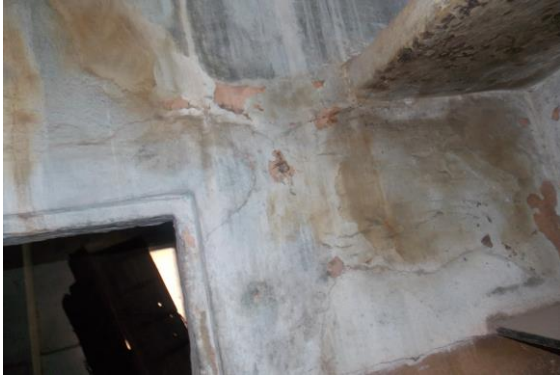
Photo 31

Peeling of Plaster on Wall No. 4 of Toilet No. 2 of House No. 2198, First Floor

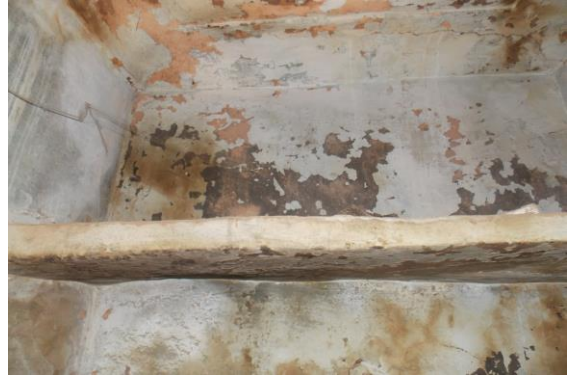
Photo 32

Peeling of Plaster on Wall No. 2 of Toilet No. 2 of House No. 2198, First Floor

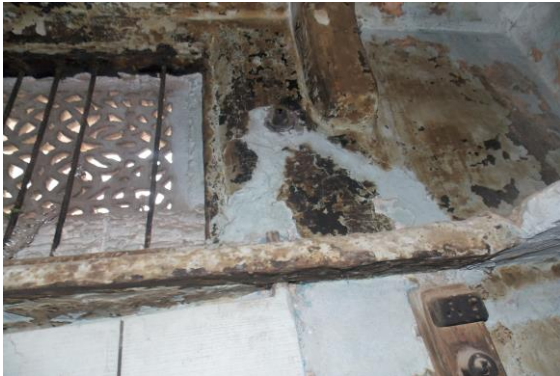
Photo 33

Peeling of Plaster on Wall No. 3 of Toilet No. 2 of House No. 2198, First Floor

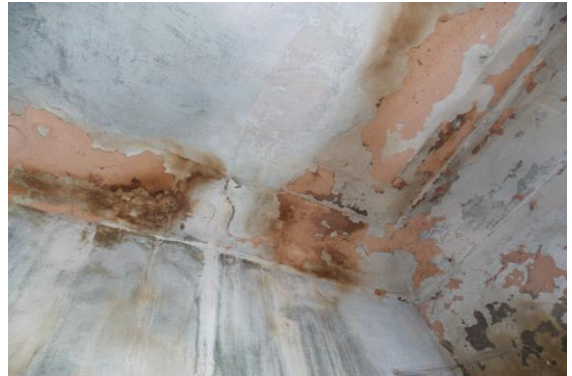
Photo 34

Peeling of Plaster on Roof of Toilet No. 2 of House No. 2198, First Floor

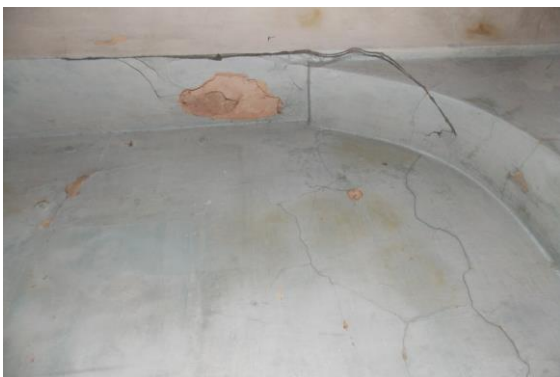
Photo 35

Peeling of Plaster on Wall No. 4 of Toilet No. 3 of House No. 2198, First Floor

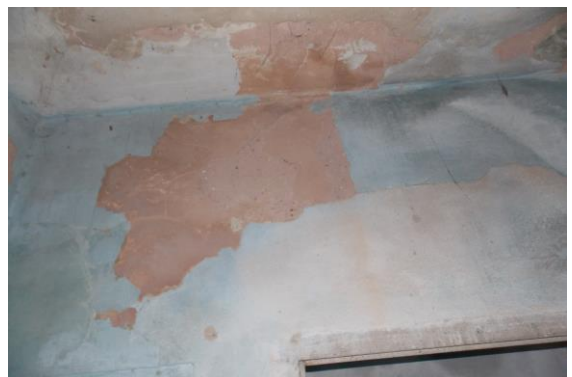
Photo 36

Peeling of Plaster on Wall No. 2 of Toilet No. 3 of House No. 2198, First Floor

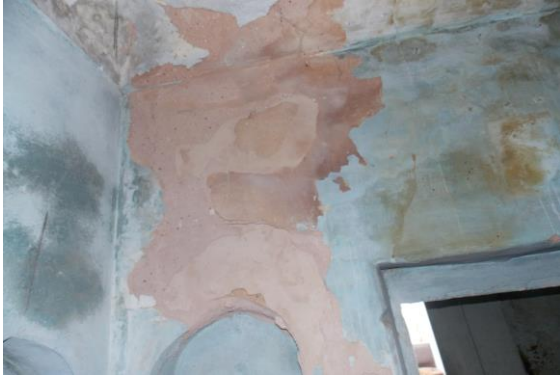
Photo 37

Peeling of Plaster on Wall No. 3 of Toilet No. 3 of House No. 2198, First Floor

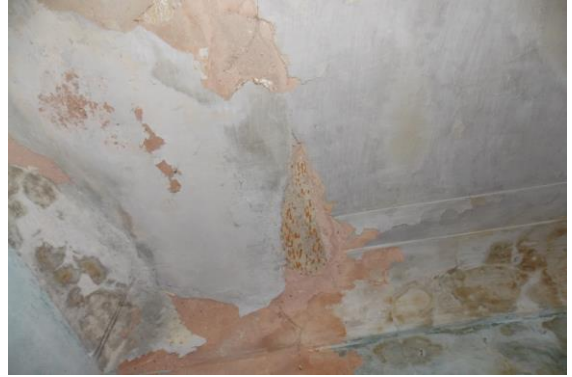
Photo 38

Peeling of Plaster on Roof of Toilet No. 3 of House No. 2198, First Floor

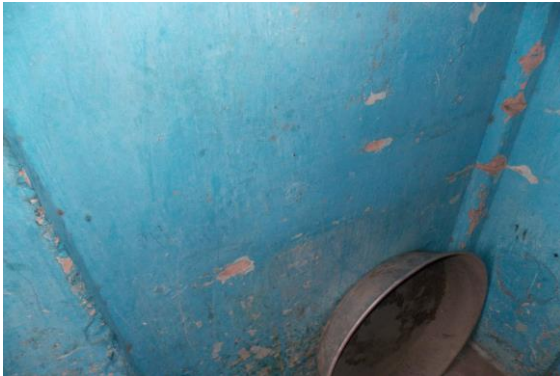
Photo 39

Peeling of Plaster on Wall No. 1 of Lobby of House No. 2198, First Floor

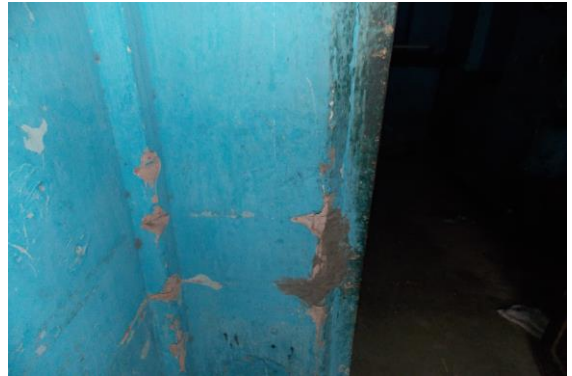
Photo 40

Peeling of Plaster on Wall No. 4 of Lobby of House No. 2198, First Floor

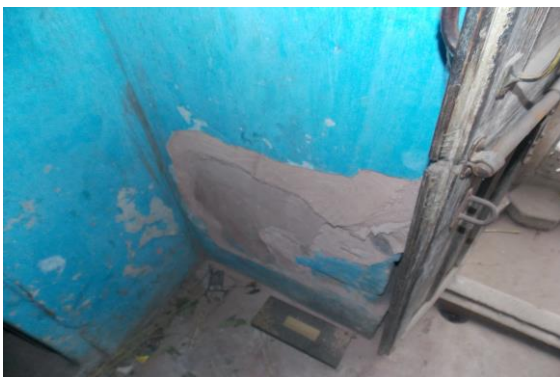
Photo 41

Peeling of Plaster on Wall No. 3 of Lobby of House No. 2198, First Floor

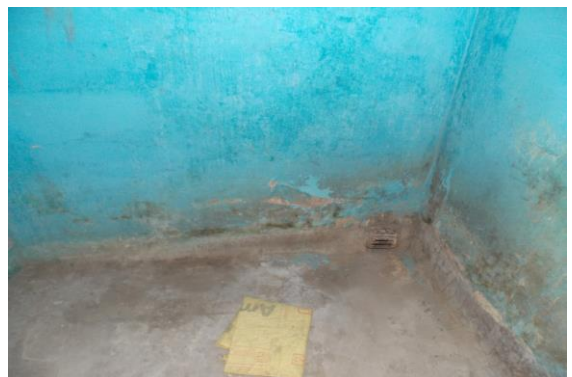
Photo 42

Peeling of Plaster on Wall No. 4 of Toilet No. 12 of House No. 2198, First Floor

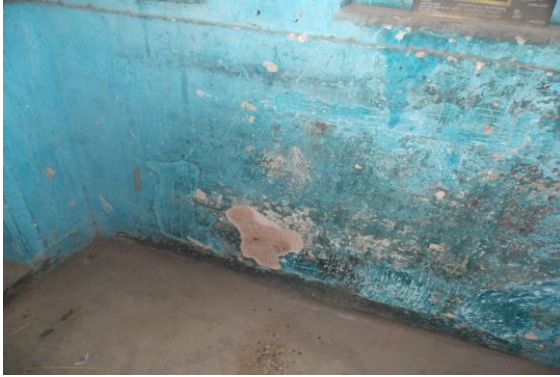
Photo 43

Peeling of Plaster on Wall No. 2 of Toilet No. 13 of House No. 2198, First Floor

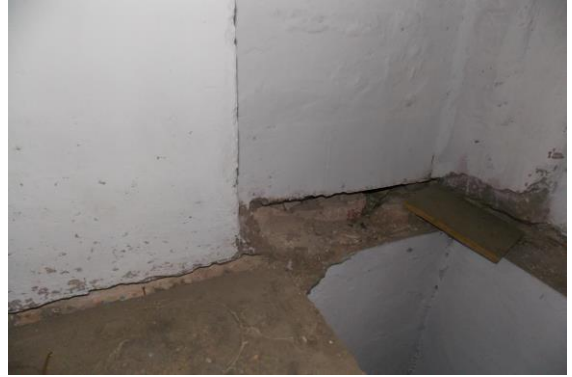
Photo 44

Peeling of Plaster on Wall No. 4 of Store 1 of House No. 2198, First Floor

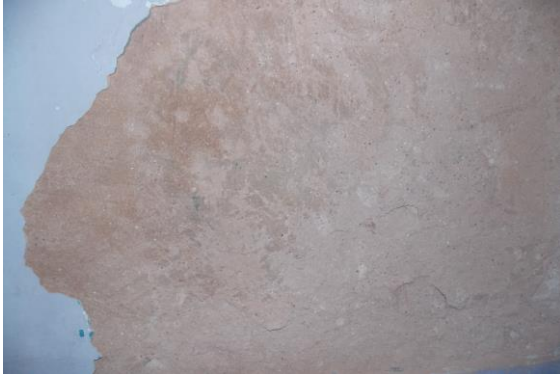
Photo 45

Peeling of Plaster on Wall No. 1 of Toilet No. 11 of House No. 2198, First Floor

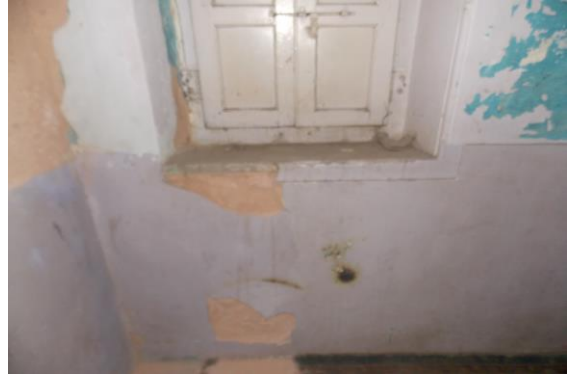
Photo 46

Peeling of Plaster on Wall No. 4 of Toilet No. 11 of House No. 2198, First Floor

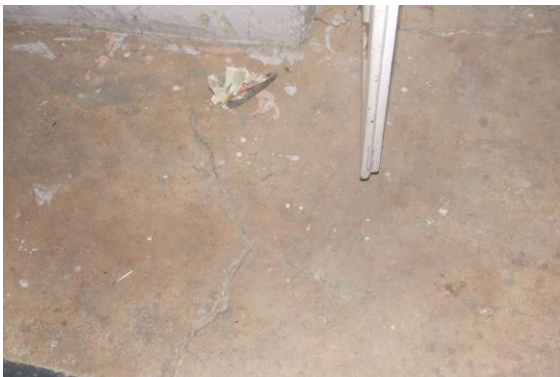
Photo 47

Peeling of Plaster on Wall No. Floor of Toilet No. 11 of House No. 2198, First Floor

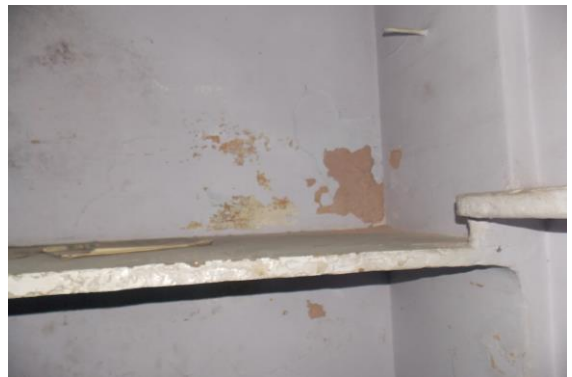
Photo 48

Peeling of Plaster on Wall No. 2 of Store 2 of House No. 2198, First Floor

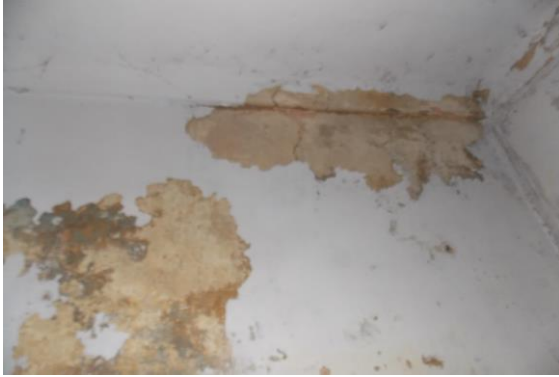
Photo 49

Peeling of Plaster on Wall No. 4 of Kitchen 2 of House No. 2198, First Floor

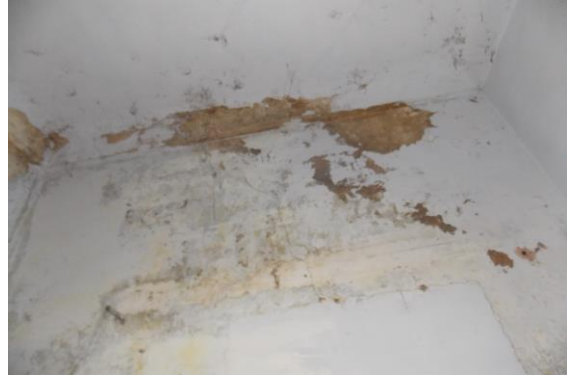
Photo 50

Peeling of Plaster on Wall No. 3 & Roof of Kitchen 2 of House No. 2198, First Floor

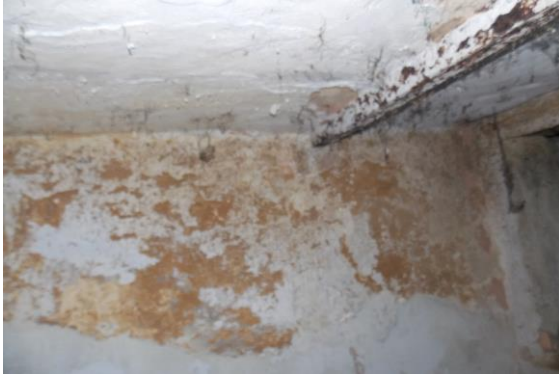
Photo 51

Peeling of Plaster on Wall No. 3 & Roof of Store 3 of House No. 2198, First Floor

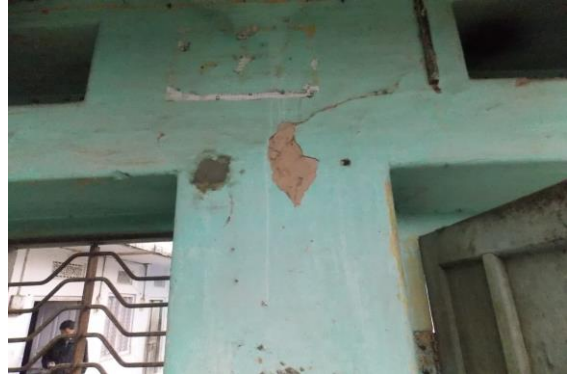
Photo 52

Peeling of Plaster on Wall No. 3 of Open Sky 2 of House No. 2198, First Floor

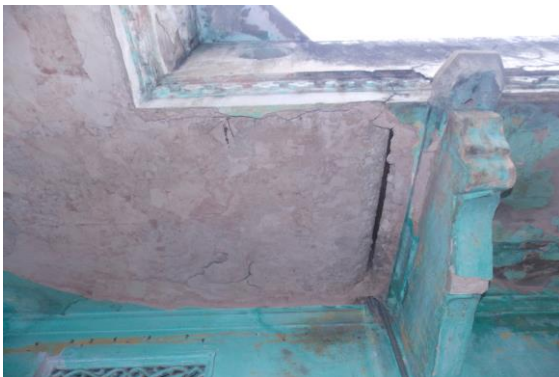
Photo 53

Peeling of Plaster on Sunshade of Open Sky 2 of House No. 2198, First Floor

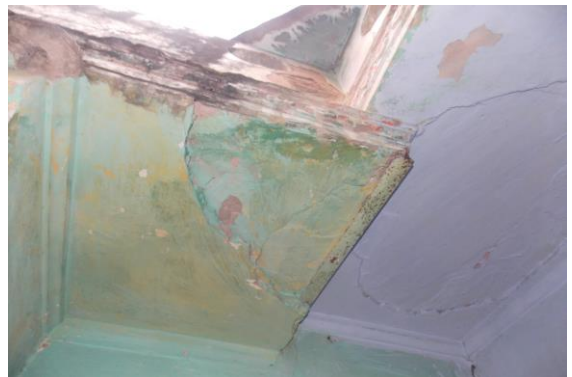
Photo 54

Peeling of Plaster on Sunshade of Open Sky 2 of House No. 2198, First Floor

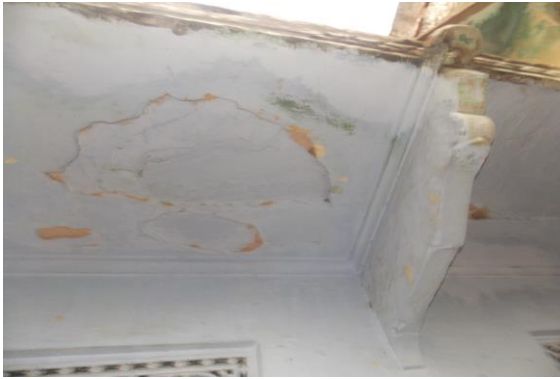
Photo 55

Peeling of Plaster on Sunshade of Open Sky 2 of House No. 2198, First Floor

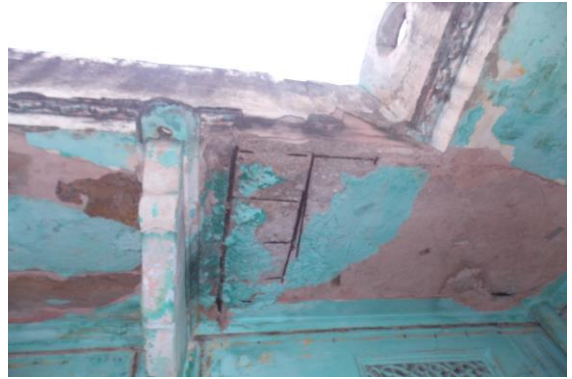
Photo 56

Peeling of Plaster on Sunshade of Open Sky 2 of House No. 2198, First Floor

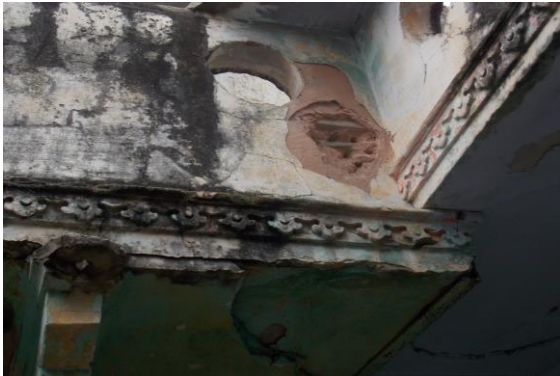
Photo 57

Peeling of Plaster on Wall No. 1 of Parapit Wall of House No. 2198, Second Floor

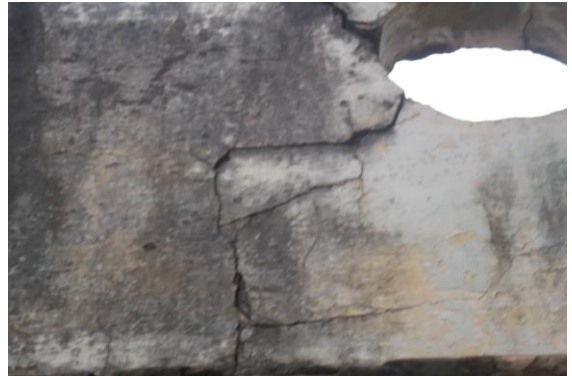
Photo 58

Damaged Portion on Wall No. 3 of Parapit Wall of House No. 2198, Second Floor

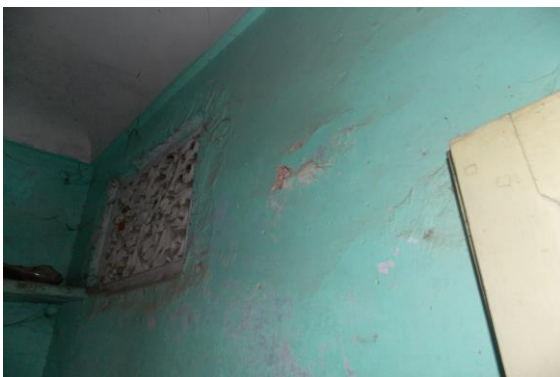
Photo 59

Peeling of Plaster on Wall No. 2 of Hall No. 1 of House No. 2198, First Floor

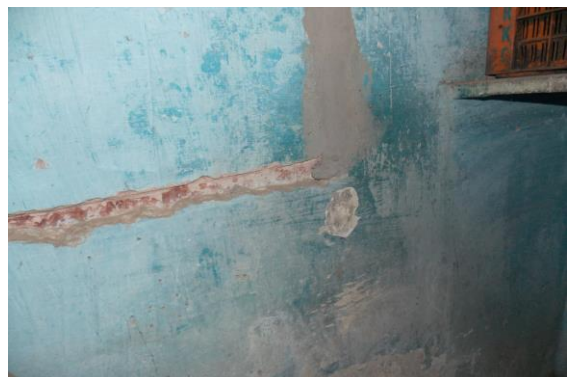
Photo 60

Peeling of Plaster on Wall No. 1 of Hall No. 2 of House No. 2198, First Floor

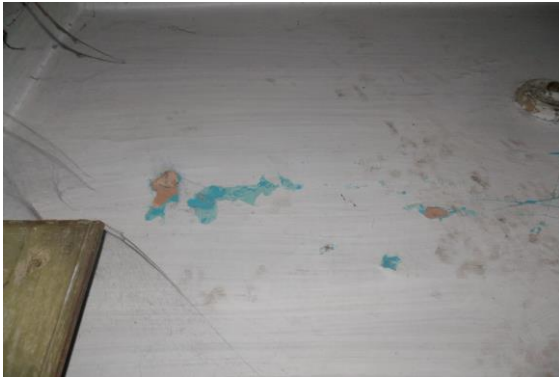
Photo 61

Peeling of Plaster on Wall No. 1 of Hall No. 4 of House No. 2198, First Floor

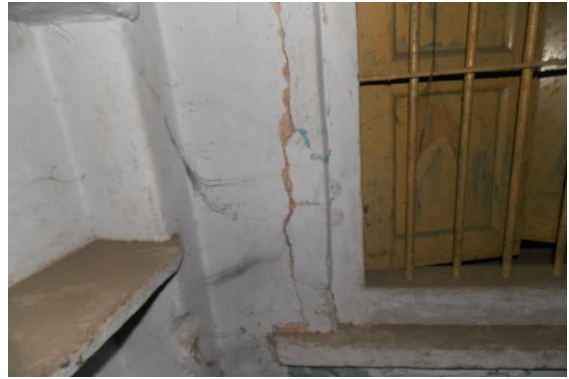
Photo 62

Damaged Portion on Wall No. 1 of Toilet No. 5 of House No. 2198, First Floor

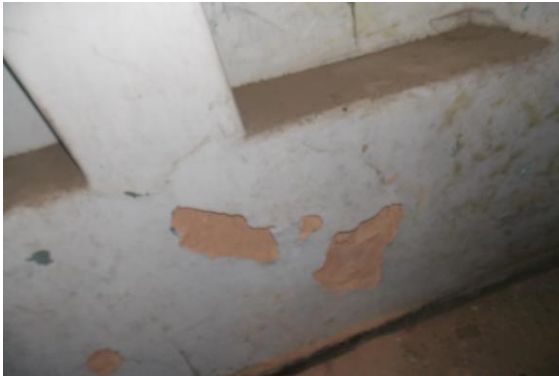
Photo 63

Peeling of Plaster on Wall No. 4 of Toilet No. 5 of House No. 2198, First Floor

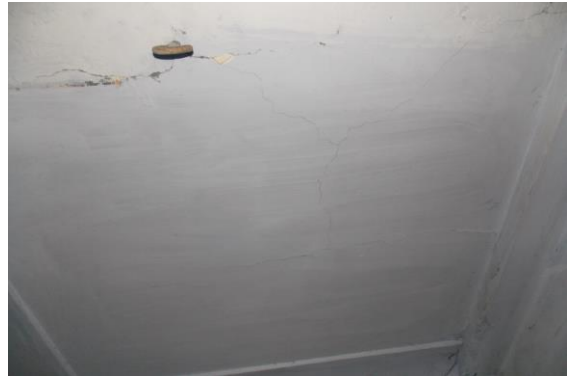
Photo 64

Plaster Crack on Roof of Toilet No. 5 of House No. 2198, First Floor

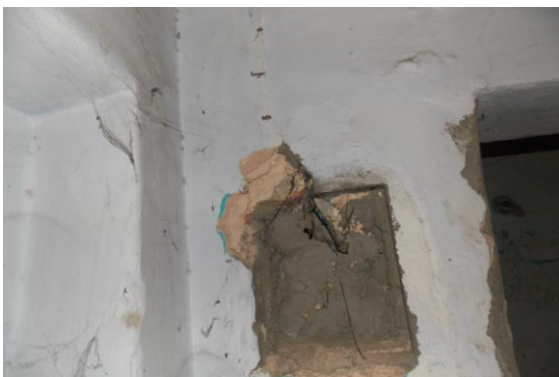
Photo 65

Peeling of Plaster on Wall No. 3 of Toilet No. 5 of House No. 2198, First Floor

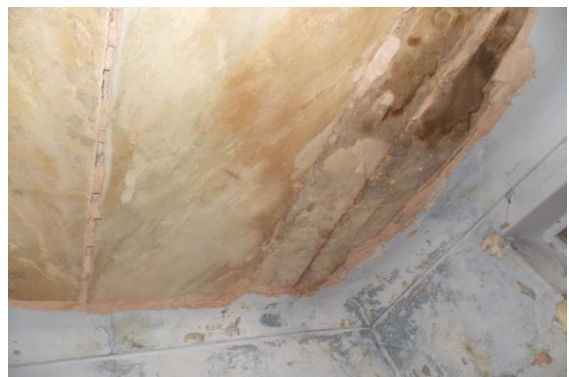
Photo 66

Peeling of Plaster on Roof of Toilet No. 6 of House No. 2198, First Floor

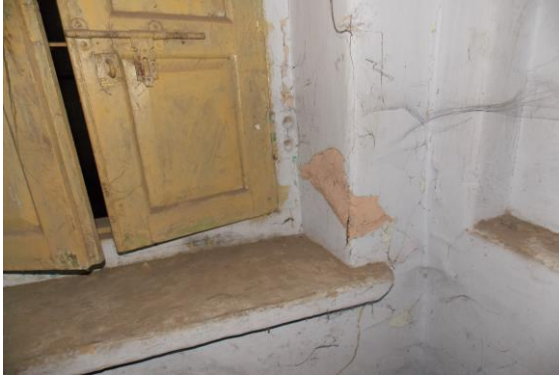
Photo 67

Peeling of Plaster on Wall No. 3 of Toilet No. 6 of House No. 2198, First Floor

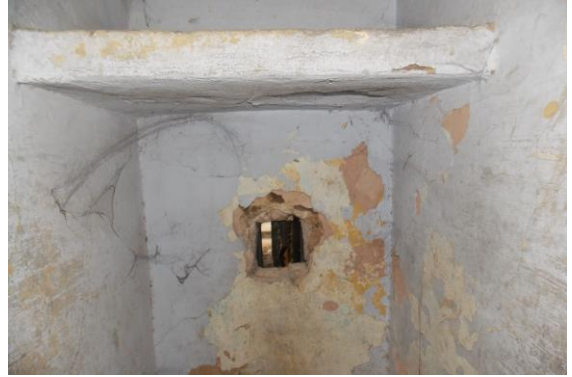
Photo 68

Peeling of Plaster on Wall No. 1 of Store 1 of House No. 2198, First Floor

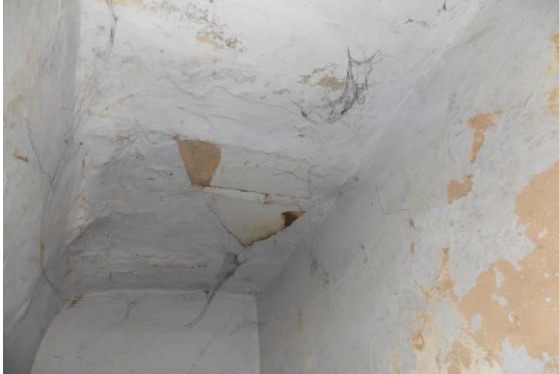
Photo 69

Peeling of Plaster on Roof of Store 1 of House No. 2198, First Floor

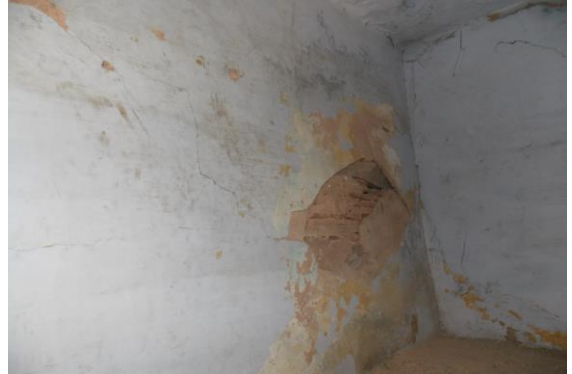
Photo 70

Peeling of Plaster on Wall No. 4 of Store 1 of House No. 2198, First Floor

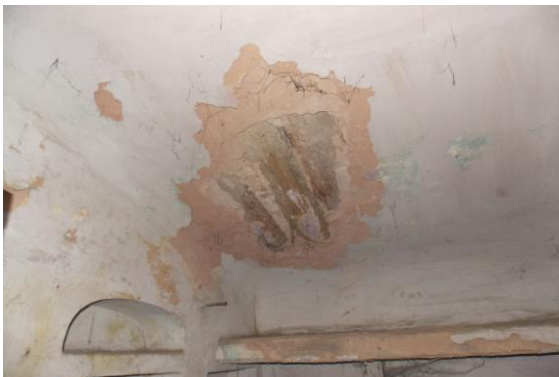
Photo 71

Peeling of Plaster on Roof of Toilet No. 7 of House No. 2198, First Floor

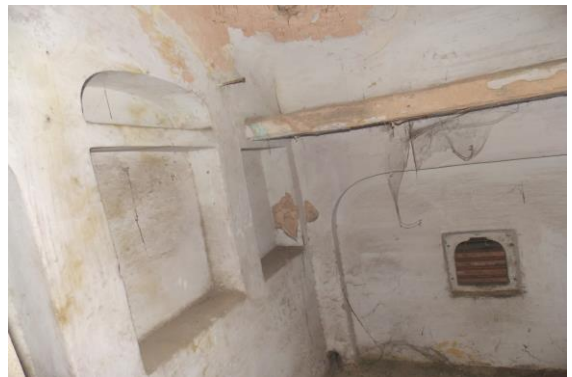
Photo 72

Peeling of Plaster on Wall No. 4 of Toilet No. 7 of House No. 2198, First Floor

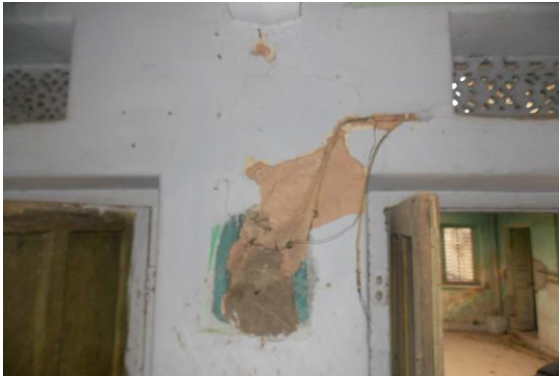
Photo 73

Peeling of Plaster on Wall No. 3 of Toilet No. 4 of House No. 2198, First Floor

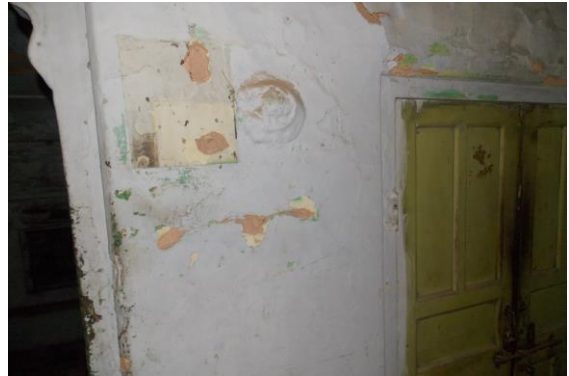
Photo 74

Peeling of Plaster on Wall No. 4 & Roof of Toilet No. 4 of House No. 2198, First Floor

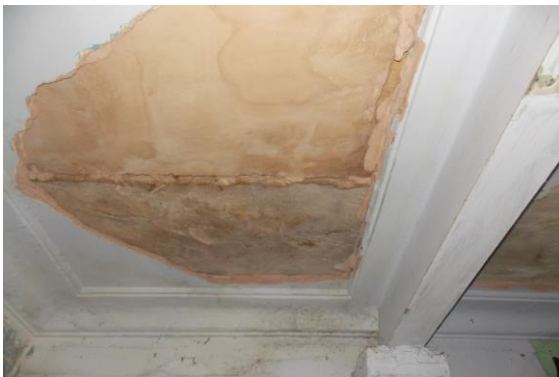
Photo 75

Peeling of Plaster on Wall No. 4 & Roof of Toilet No. 4 of House No. 2198, First Floor

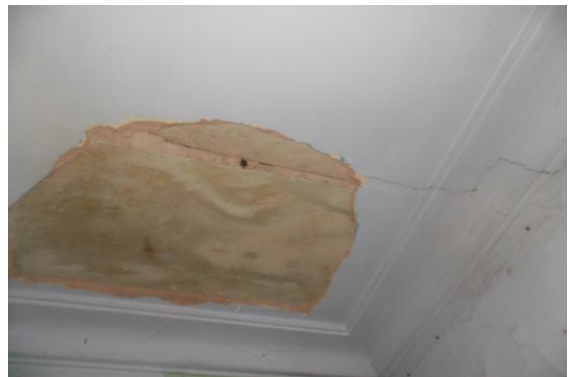
Photo 76

Peeling of Plaster on Wall No. 4 & Roof of Toilet No. 4 of House No. 2198, First Floor

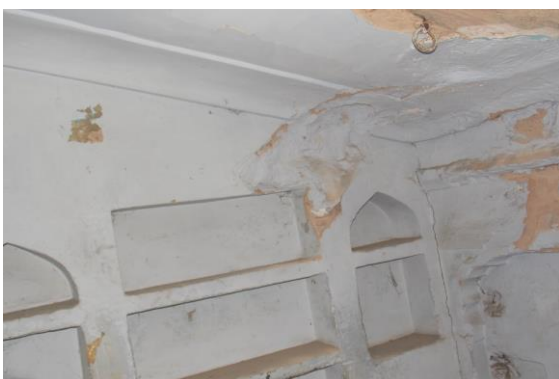
Photo 77

Peeling of Plaster on Wall No. 1 of Toilet No. 8 of House No. 2198, First Floor

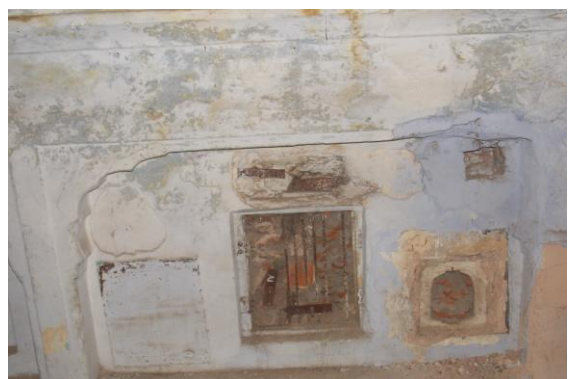
Photo 78

Peeling of Plaster on Wall No. 4 of Toilet No. 8 of House No. 2198, First Floor

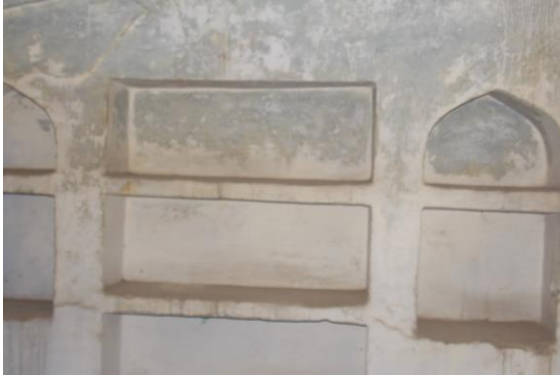
Photo 79

Dampness/Seepage on Wall No. 2 of Toilet No. 8 of House No. 2198, First Floor

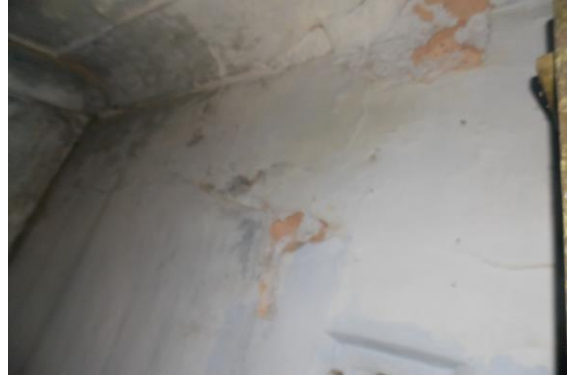
Photo 80

Peeling of Plaster on Wall No. 3 of Toilet No. 8 of House No. 2198, First Floor

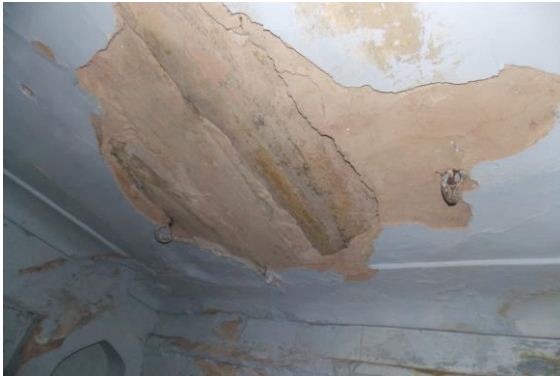
Photo 81

Peeling of Plaster on Roof of Toilet No. 8 of House No. 2198, First Floor

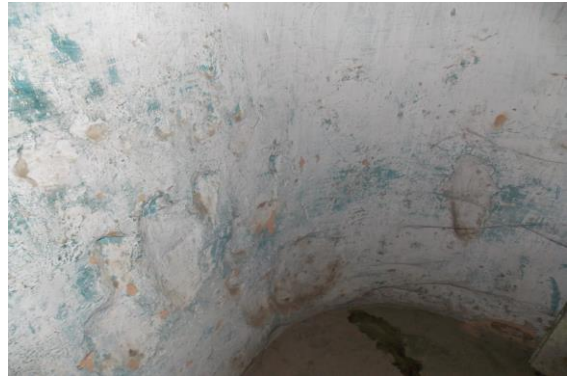
Photo 82

Peeling of Plaster on Wall No. 2 & 4 of Lobby 2 of House No. 2198, First Floor

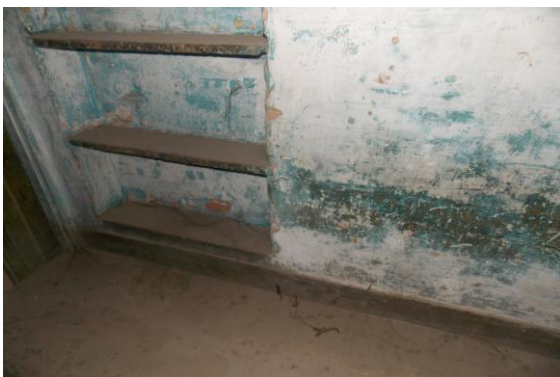
Photo 83

Peeling of Plaster on Wall No. 1 of Toilet No. 15 of House No. 2198, First Floor

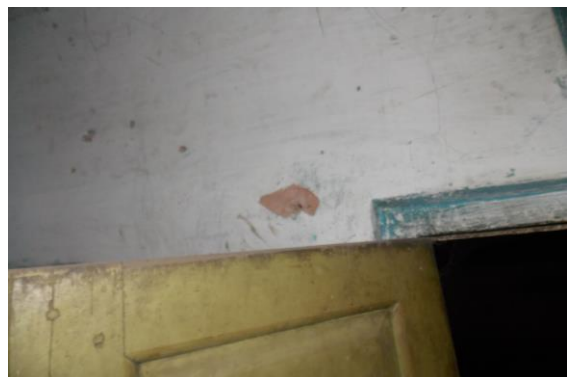
Photo 84

Peeling of Plaster on Wall No. 2 of Toilet No. 15 of House No. 2198, First Floor

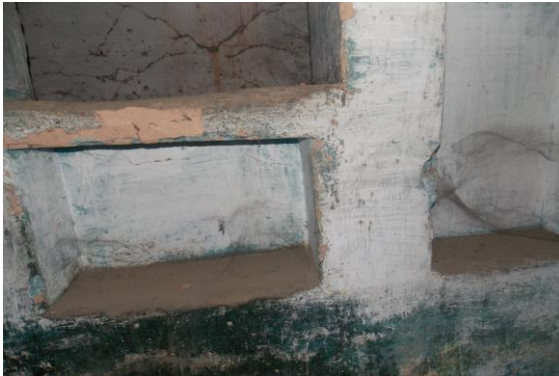
Photo 85

Peeling of Plaster on Wall No. 4 of Toilet No. 15 of House No. 2198,  
First Floor
