### Pre Building Condition Survey Report

Name and Address of Structure :	Badi Chopar to Ramp Area (UP Line)
---------------------------------	------------------------------------

Name of the Project	<b>Contract JMRC-UG1B</b> “Design and Construction of Tunnel between Chandpole and Badi Chouper and reverse line by Shield TBM, Underground Metro Stations at Choti Chouper and Badi Chouper by Cut and Cover Methods on East West Corridor of Jaipur Metro Rail Corporation Limited .”	
Owner :

Pre Building Condition Survey Report Badi Chopar to Ramp Area (UP Line)

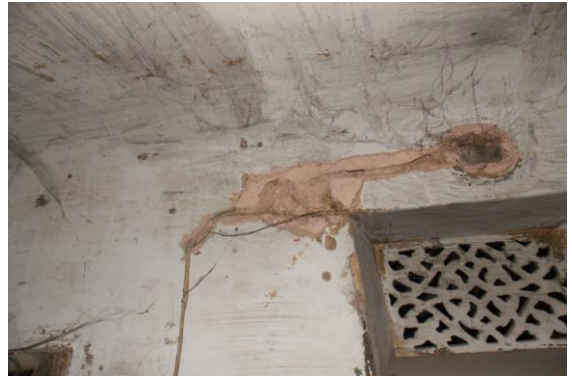
Photo 86

Peeling of Plaster on Wall No. 3 of Toilet No. 16 of House No. 2198,  
First Floor

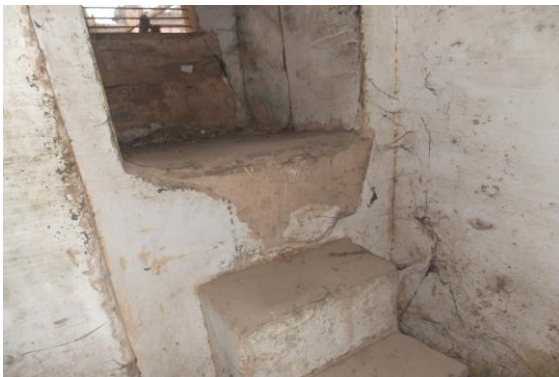
Photo 87

Peeling of Plaster on Wall No. 1 of Toilet No. 16 of House No. 2198,  
First Floor

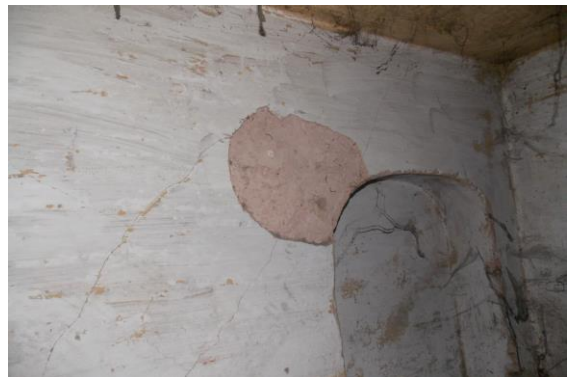
Photo 88

Peeling of Plaster on Wall No. 4 of Toilet No. 16 of House No. 2198,  
First Floor

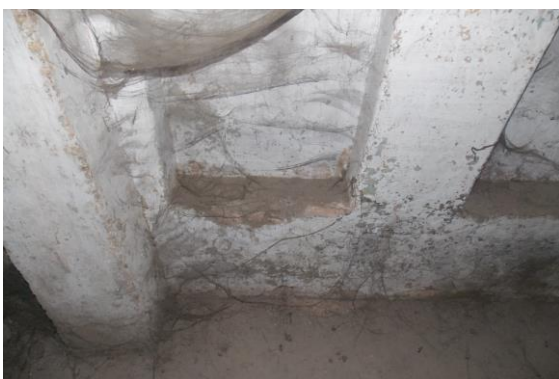
Photo 89

Peeling of Plaster on Wall No. 2 of Toilet No. 16 of House No. 2198,  
First Floor

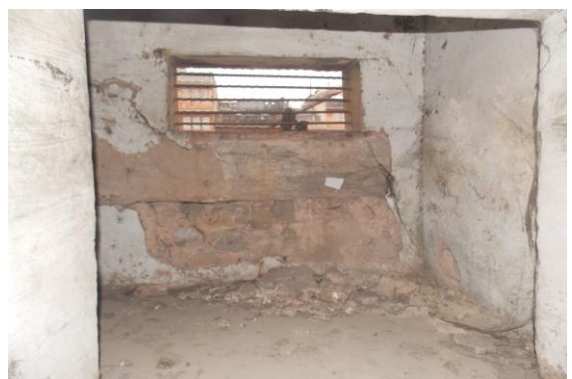
Photo 90

Peeling of Plaster on Wall No. 4 of Toilet No. 1 of House No. 2198, First  
Floor

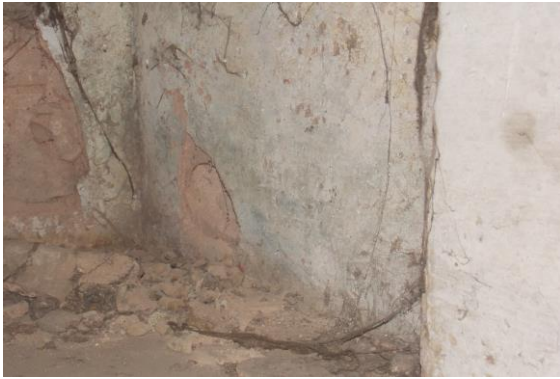
Photo 91

Peeling of Plaster on Wall No. 2 of Toilet No. 1 of House No. 2198, First Floor

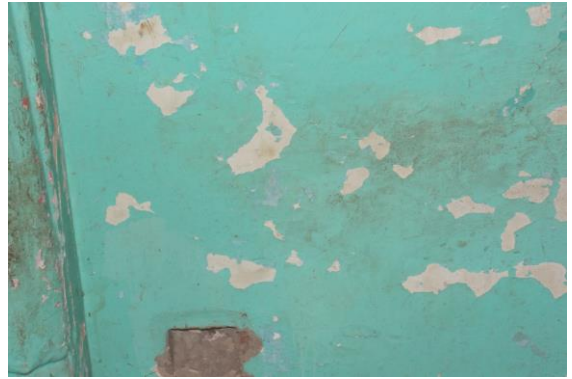
Photo 92

Peeling of Plaster on Wall No. 1 of Toilet No. 9 of House No. 2198, First Floor

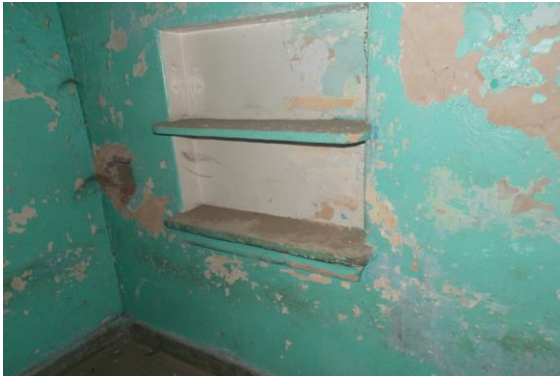
Photo 93

Peeling of Plaster on Wall No. 4 of Toilet No. 9 of House No. 2198, First Floor

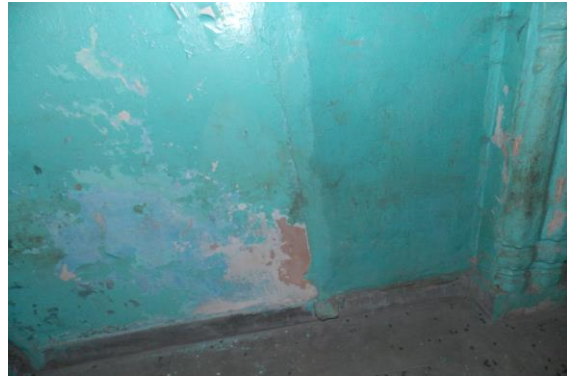
Photo 94

Peeling of Plaster on Wall No. 2 of Toilet No. 9 of House No. 2198, First Floor

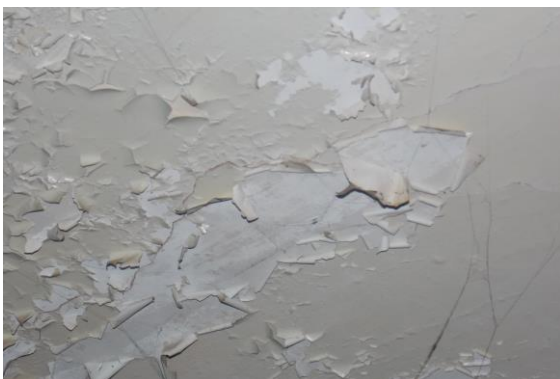
Photo 95

Peeling of Plaster on Roof of Toilet No. 9 of House No. 2198, First Floor

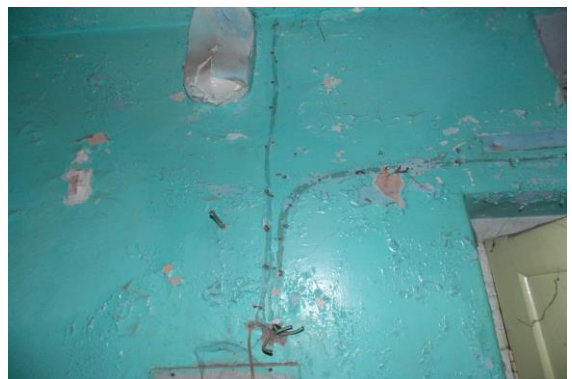
Photo 96

Peeling of Plaster on Wall No. 3 of Toilet No. 9 of House No. 2198, First Floor

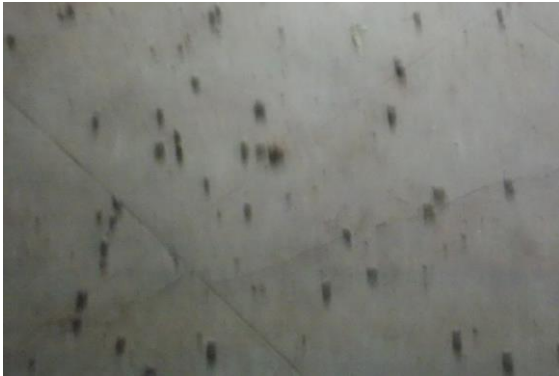
Photo 97  
Plaster Crack on Floor of Toilet No. 9 of House No. 2198, First Floor

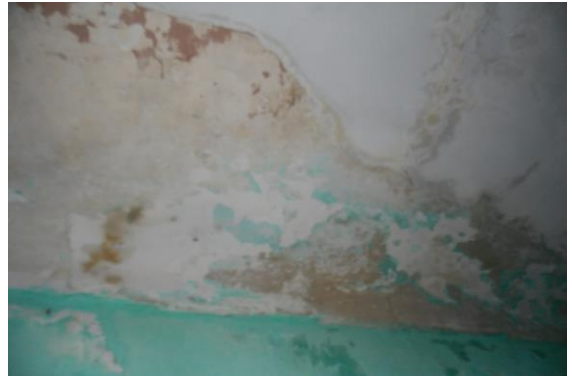
Photo 98  
Dampness/Seepage on Roof of Toilet No. 10 of House No. 2198, First Floor

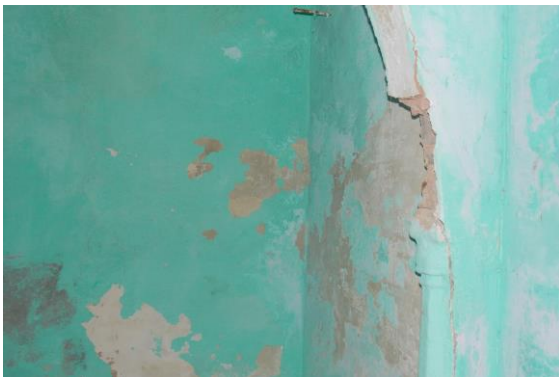
Photo 99  
Peeling of Plaster on Wall No. 2 & 3 of Toilet No. 10 of House No. 2198, First Floor

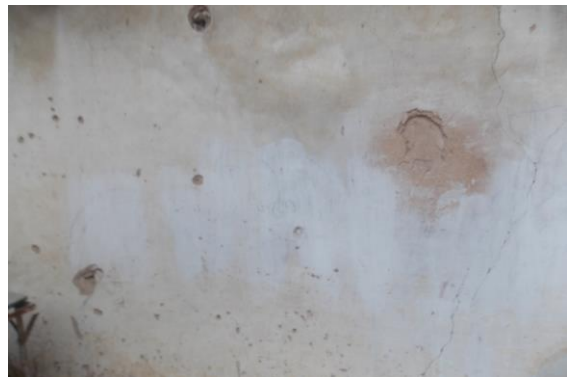
Photo 100  
Peeling of Plaster on Wall No. 1 of Open Sky 1 of House No. 2198, First Floor

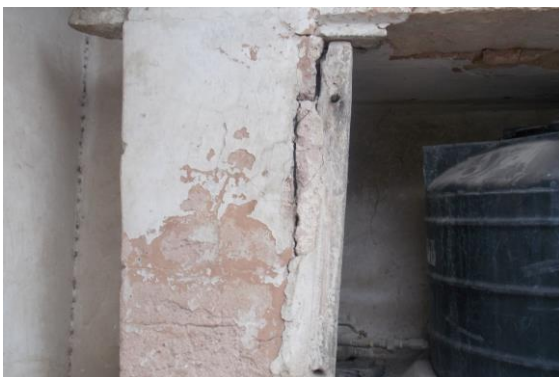
Photo 101  
Peeling of Plaster on Wall No. 4 of Open Sky 1 of House No. 2198, First Floor

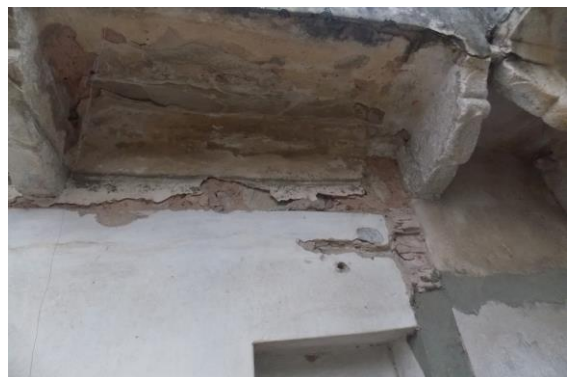
Photo 102  
Peeling of Plaster on Wall No. 4 of Open Sky 1 of House No. 2198, First Floor

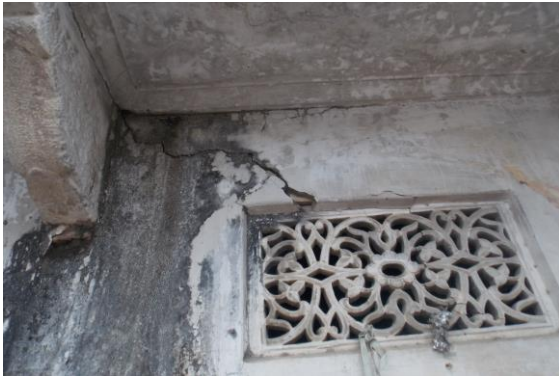
Photo 103

Peeling of Plaster on Wall No. 2 of Open Sky 1 of House No. 2198, First Floor

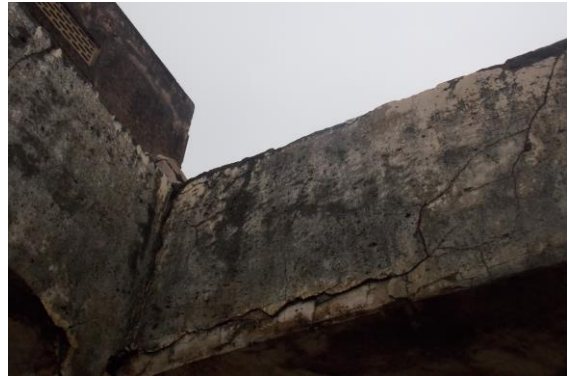
Photo 104

Damaged Portion on Wall No. 3 of Parapit Wall of House No. 2198, Second Floor

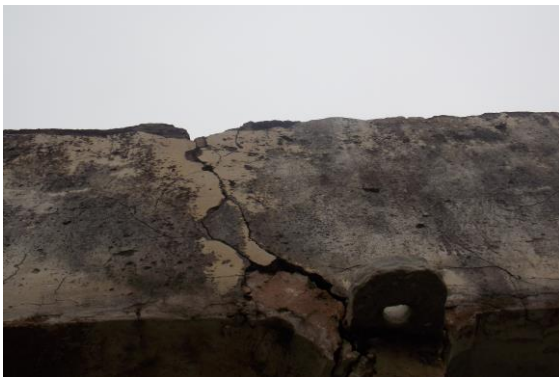
Photo 105

Damaged Portion on Wall No. 3 of Parapit Wall of House No. 2198, Second Floor

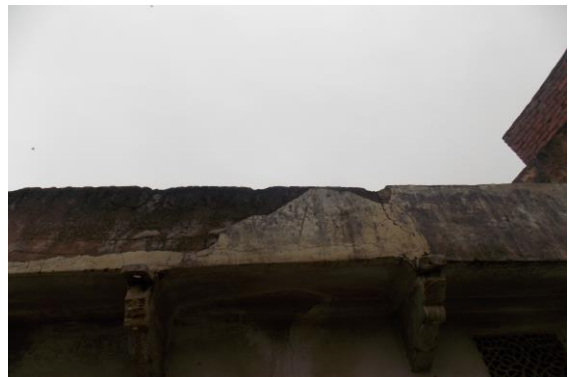
Photo 106

Damaged Portion on Wall No. 3 of Parapit Wall of House No. 2198, Second Floor

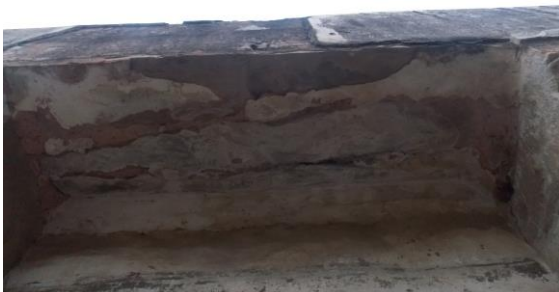
Photo 107

Damaged Portion on Sunshade & Roof of House No. 2198, First Floor

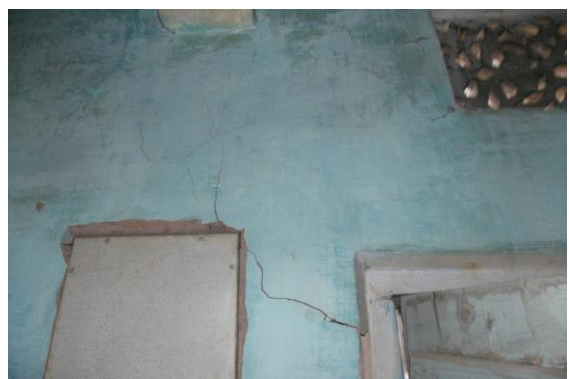
Photo 108

Peeling of Plaster on Wall No. 3 of Hall No. 1 of House No. 2198, First Floor

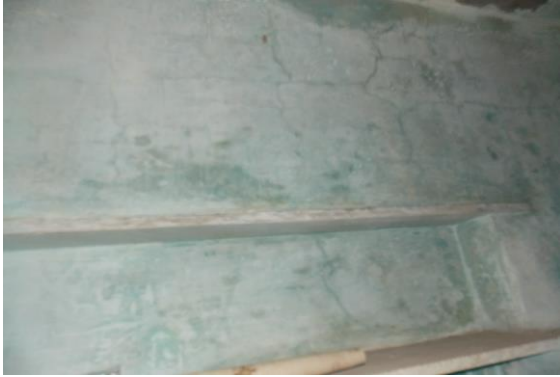
Photo 109

Dampness/Seepage on Wall No. 1 of Hall No. 1 of House No. 2198, First Floor

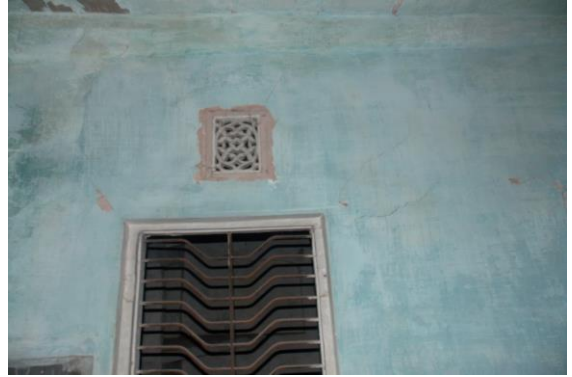
Photo 110

Peeling of Plaster on Wall No. 4 of Hall No. 1 of House No. 2198, First Floor

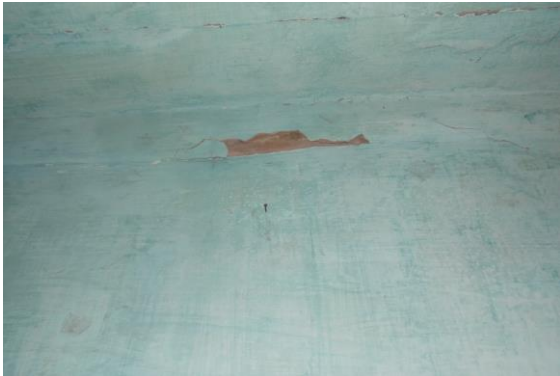
Photo 111

Peeling of Plaster on Wall No. 2 of Hall No. 1 of House No. 2198, First Floor

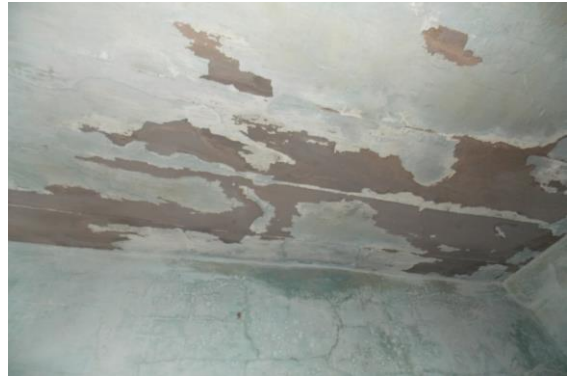
Photo 112

Peeling of Plaster on Roof of Hall No. 1 of House No. 2198, First Floor

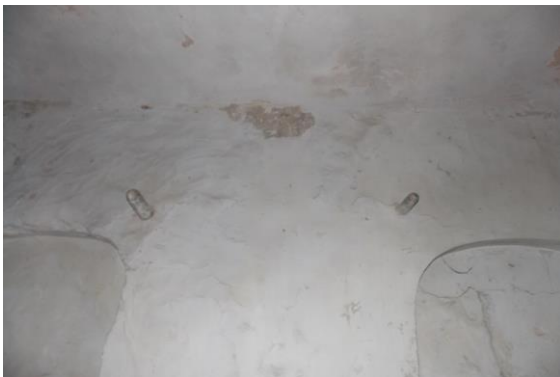
Photo 113

Dampness/Seepage on Wall No. 4 of Hall No. 2 of House No. 2198, First Floor

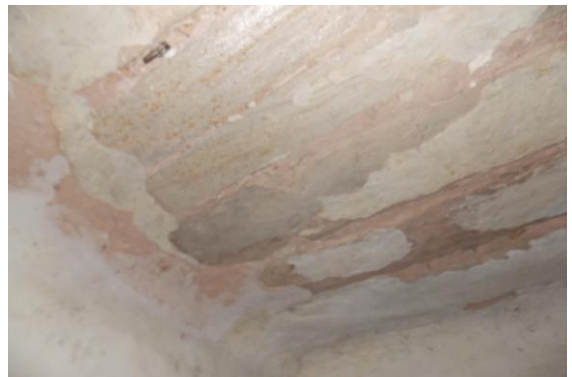
Photo 114

Dampness/Seepage on Roof of Hall No. 2 of House No. 2198, First Floor

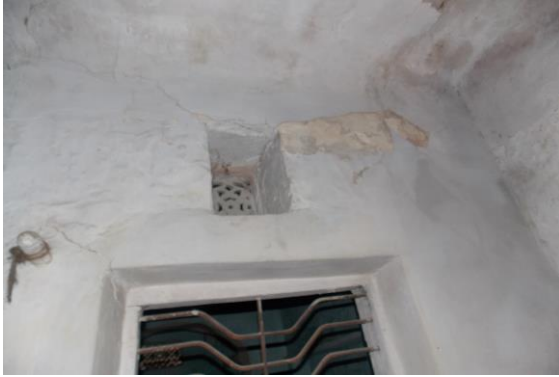
Photo 115

Peeling of Plaster on Wall No. 3 of Hall No. 2 of House No. 2198, First Floor

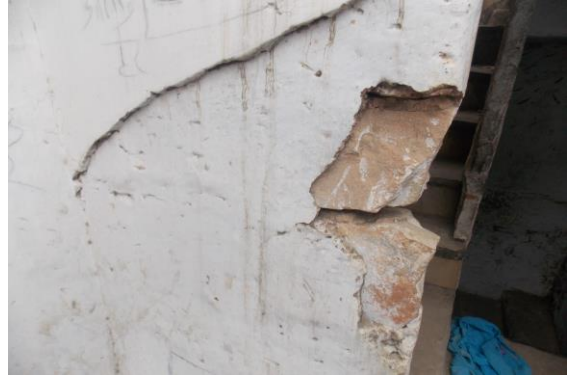
Photo 116

Peeling of Plaster on Wall No. 3 of Open Sky 3 of House No. 2198, First Floor

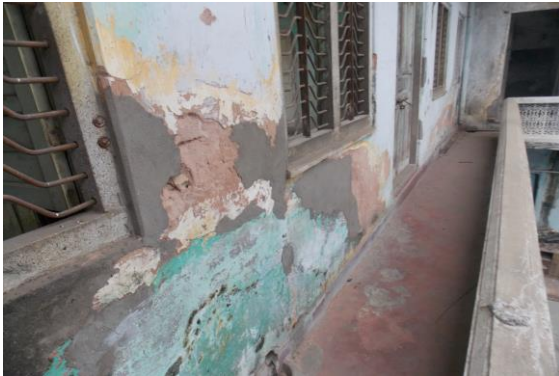
Photo 117

Peeling of Plaster on Wall No. 1 of Open Sky 3 of House No. 2198, First Floor

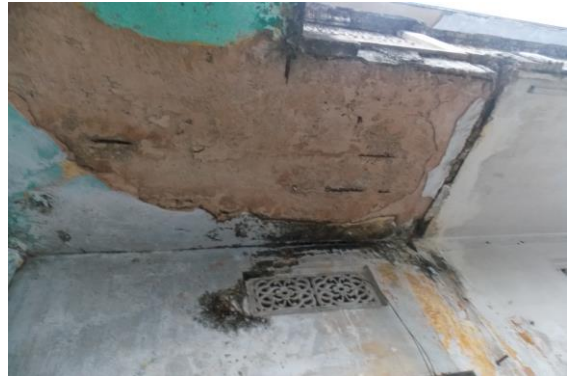
Photo 118

Peeling of Plaster on Wall No. 1, 4 & Sunshade of Open Sky 3 of House No. 2198, First Floor

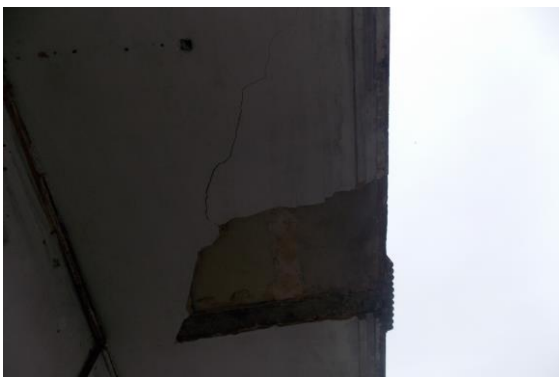
Photo 119

Peeling of Plaster on Wall No. 4 & Sunshade of Open Sky 3 of House No. 2198, First Floor

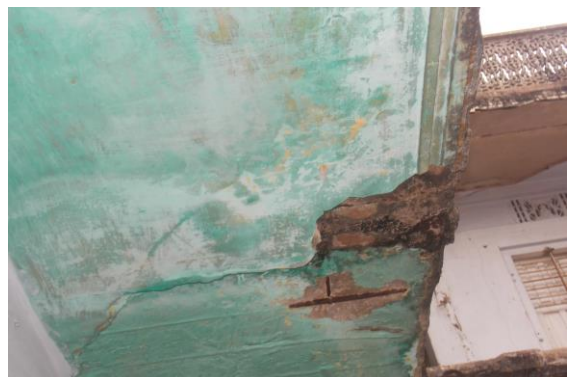
Photo 120

Peeling of Plaster on Wall No. 1 & Sunshade of Open Sky 3 of House No. 2198, First Floor

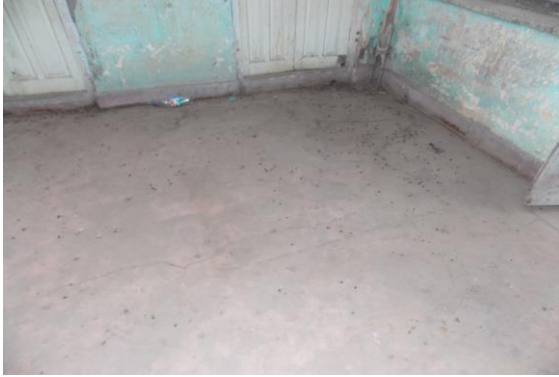
Photo 121

Plaster Crack on Wall No. 2 of Open Sky 2 of House No. 2198, First Floor

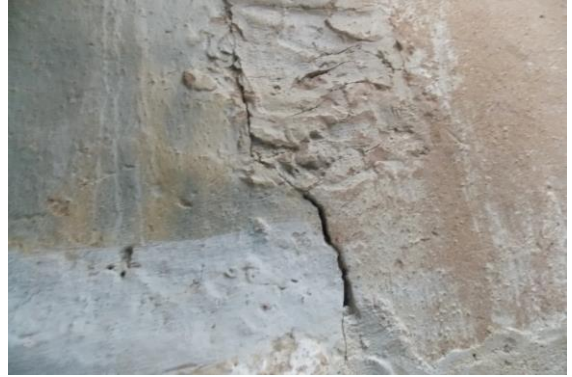
Photo 122

Peeling of Plaster on Wall No. 1 of Stair First Floor to Second Floor of House No. 2198, First Floor

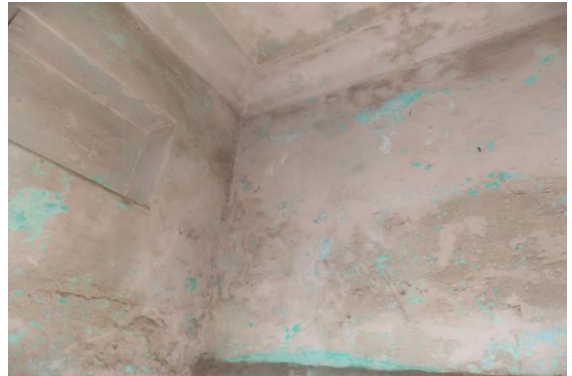
Photo 123

Peeling of Plaster on Wall No. 2 of Stair First Floor to Second Floor of House No. 2198, First Floor

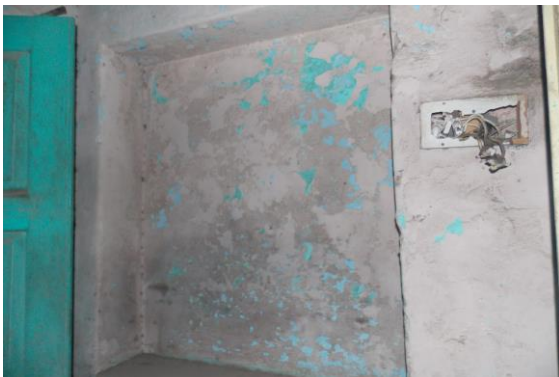
Photo 124

Dampness/Seepage on Wall No. 1, 4 & Roof of Kitchen 1 of House No. 2198, Second Floor

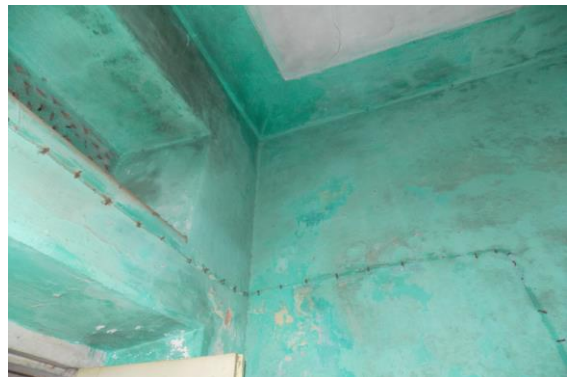
Photo 125

Dampness/Seepage on Wall No. 3 of Kitchen 1 of House No. 2198, Second Floor

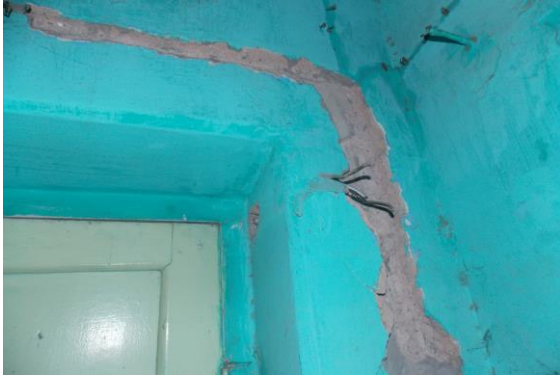
Photo 126

Dampness/Seepage on Wall No. 1, 4 & Roof of Kitchen 2 of House No. 2198, Second Floor

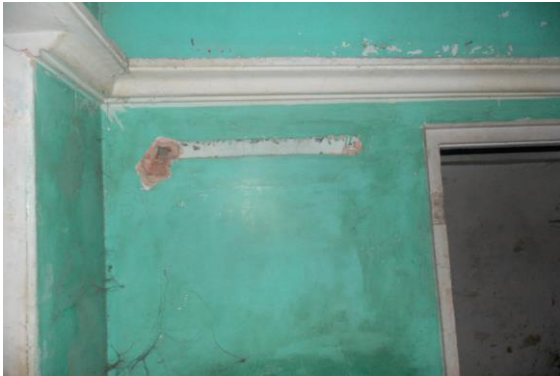
Photo 128

Damaged Portion on Roof of Toilet No. 3 of House No. 2198, Second Floor

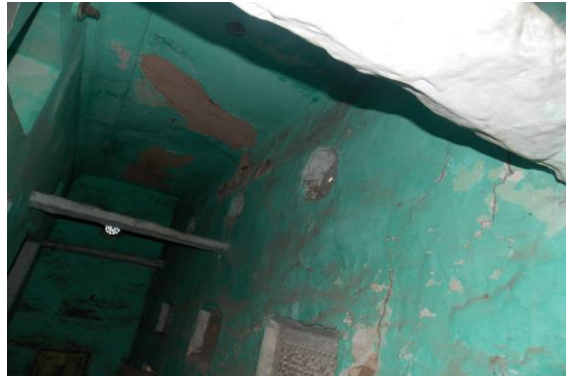
Photo 129

Peeling of Plaster on Wall No. 4 of Toilet No. 3 of House No. 2198, Second Floor

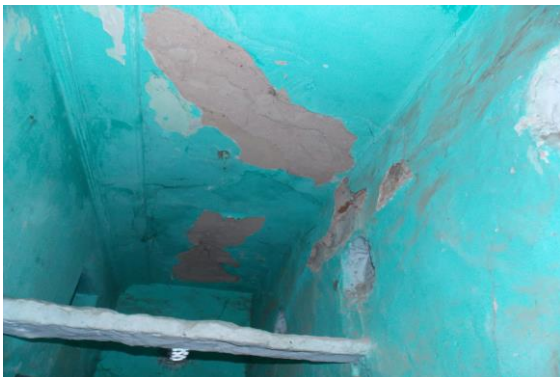
Photo 130

Damaged Portion on Wall No. 2 & 4 of Gallery of House No. 2198, Second Floor

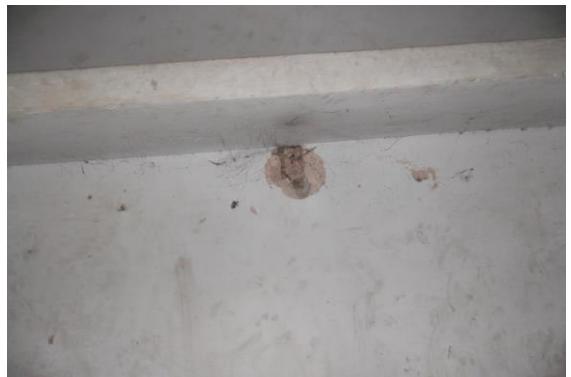
Photo 131

Damaged Portion on Wall No. 2 & 4 of Gallery of House No. 2198, Second Floor

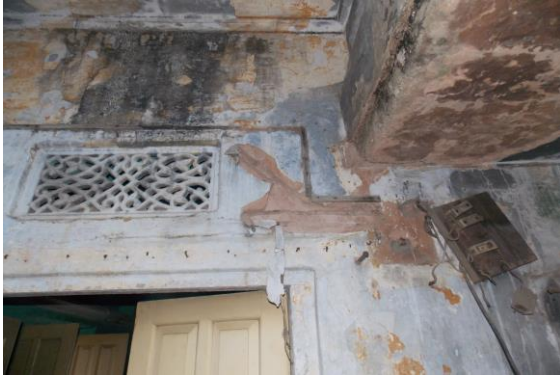
Photo 132

Peeling of Plaster on Wall No. 4 of Store 2 of House No. 2198, Second Floor

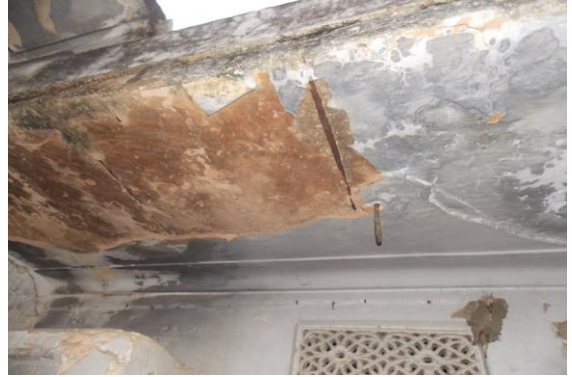
Photo 133

Peeling of Plaster on Wall No. 3 of Open Sky 4 of House No. 2198, Second Floor

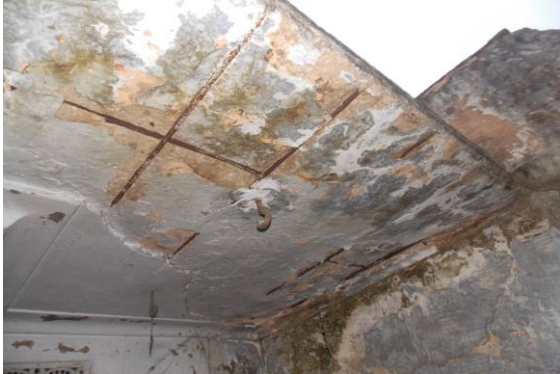
Photo 134

Peeling of Plaster on Wall No. 3 & Sunshade of Open Sky 4 of House No. 2198, Second Floor

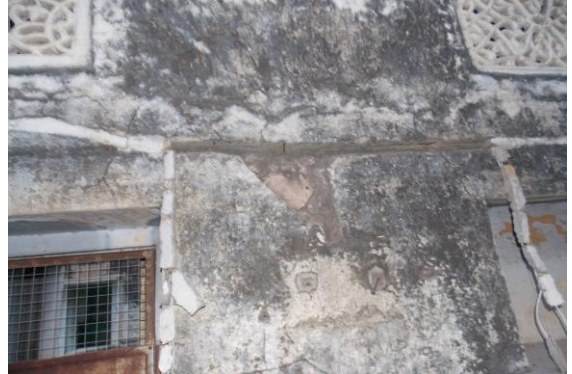
Photo 135

Peeling of Plaster on Wall No. 3 & Sunshade of Open Sky 4 of House No. 2198, Second Floor

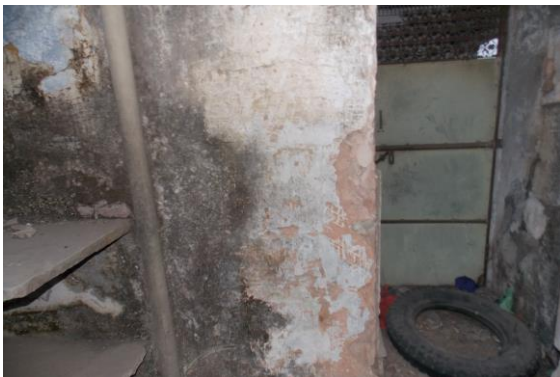
Photo 136

Peeling of Plaster on Wall No. 2 of Open Sky 4 of House No. 2198, Second Floor

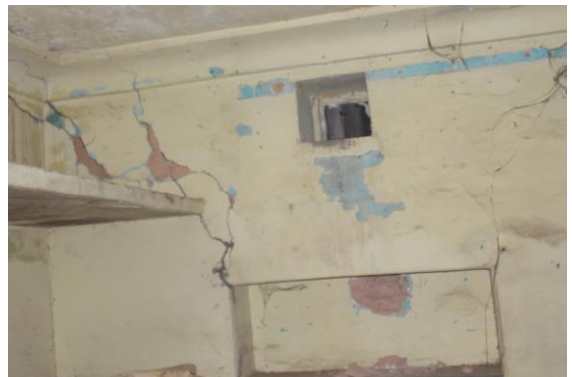
Photo 137

Peeling of Plaster on Wall No. 4 of Open Sky 5 of House No. 2198, Second Floor

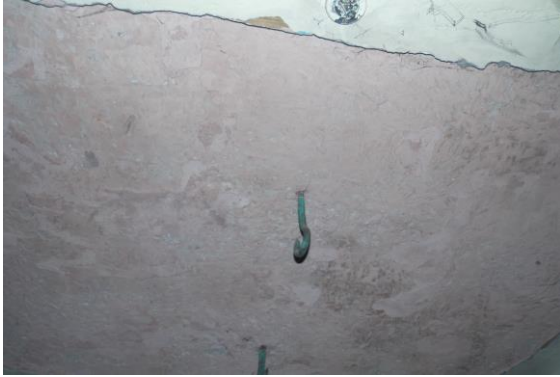
Photo 138

Damaged Portion on Wall No. 4 of Toilet No. 2 of House No. 2198, Second Floor

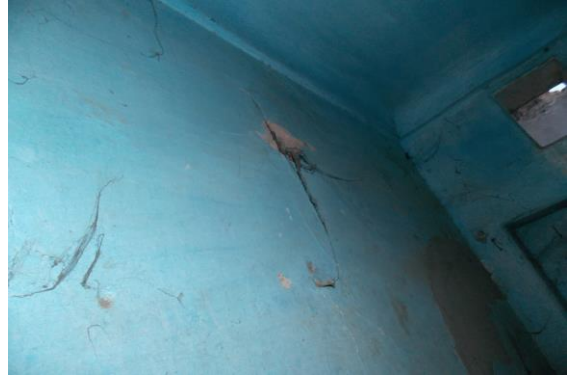
Photo 139

Damaged Portion on Roof of Toilet No. 2 of House No. 2198, Second Floor

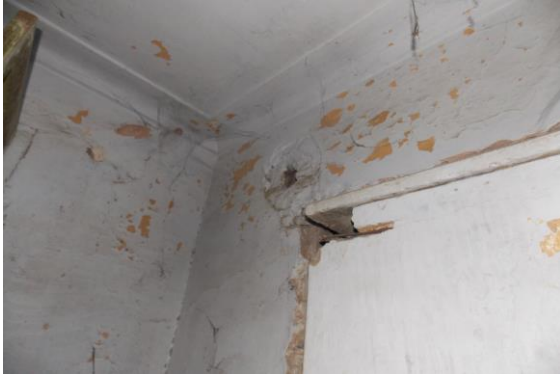
Photo 140

Damaged Portion on Wall No. 1 of Store 1 of House No. 2198, Second Floor

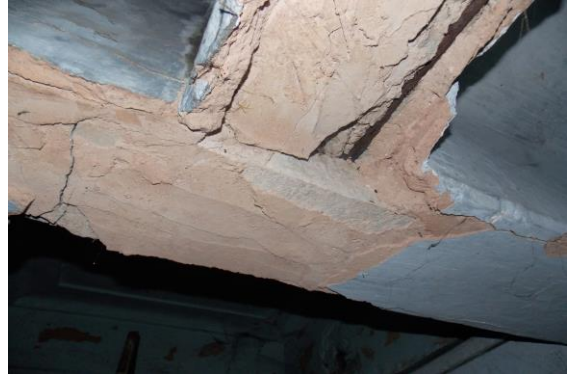
Photo 141

Damaged Portion on Wall No. 2 of Lobby 1 of House No. 2198, Second Floor

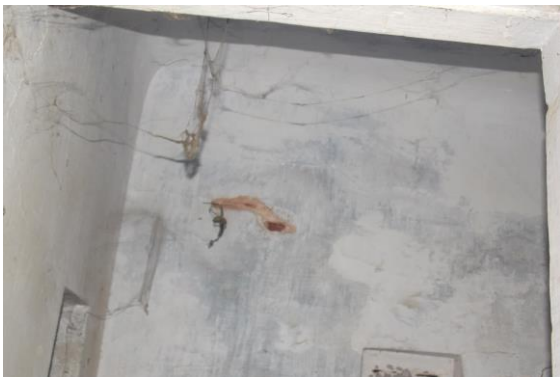
Photo 142

Damaged Portion on Roof of Lobby 1 of House No. 2198, Second Floor

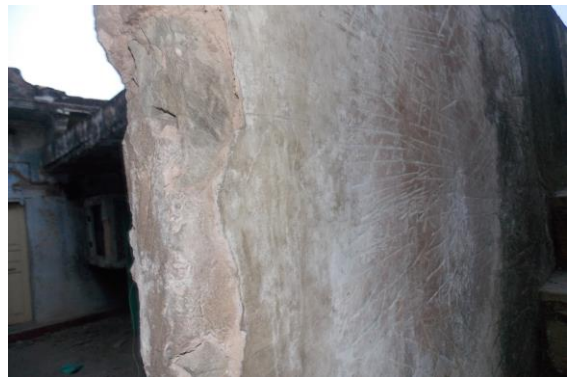
Photo 143

Peeling of Plaster on Wall No. 4 of Bathroom of House No. 2198, Second Floor

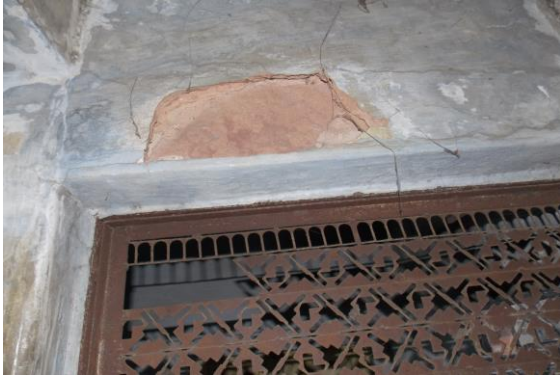
Photo 144

Peeling of Plaster on Wall No. 3 of Stair Second Floor to Terrace of House No. 2198, Second Floor

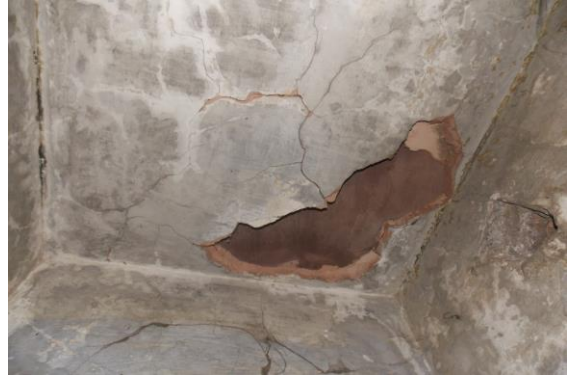
Photo 145

Damaged Portion on Wall No. 4 of Stair Second Floor to Terrace of House No. 2198, Second Floor

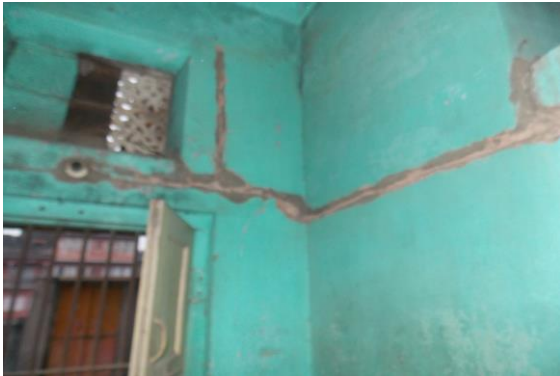
Photo 146

Damaged Portion on Roof of Stair Second Floor to Terrace of House No. 2198, Second Floor

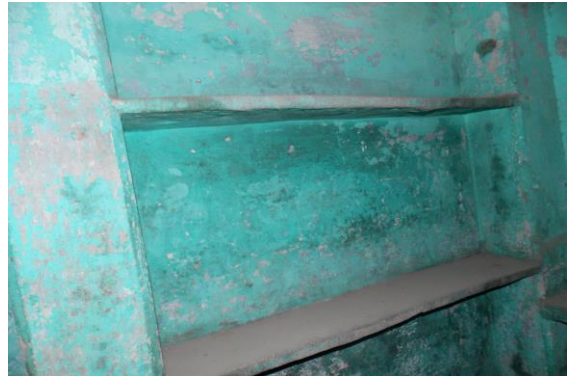
Photo 147

Peeling of Plaster on Wall No. 2 & 4 of Kitchen 3 of House No. 2198, Second Floor

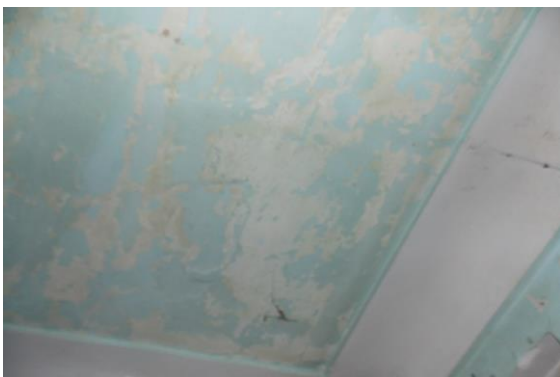
Photo 148

Dampness/Seepage on Wall No. 1 of Kitchen 3 of House No. 2198, Second Floor

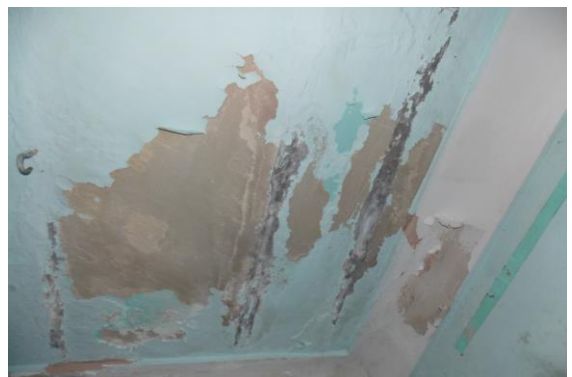
Photo 149

Peeling of Plaster on Roof of Toilet No. 6 of House No. 2198, Second Floor

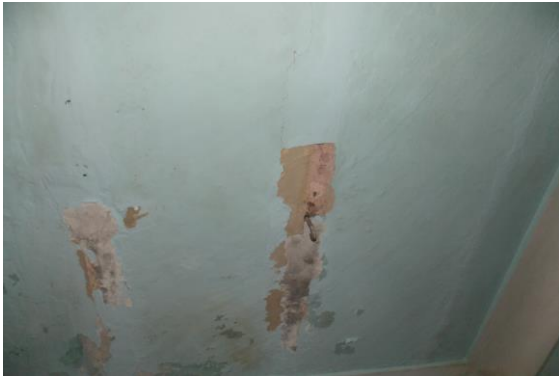
Photo 150

Dampness/Seepage on Roof of Toilet No. 7 of House No. 2198, Second Floor

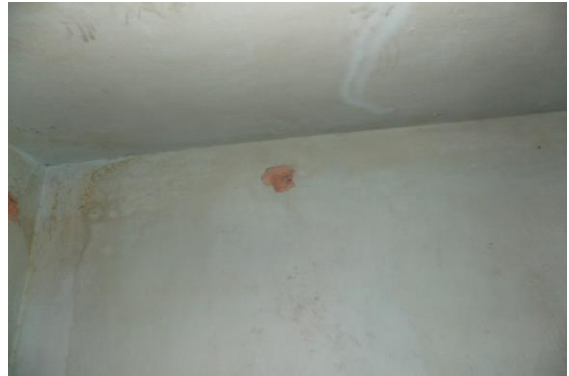
Photo 151

Peeling of Plaster on Wall No. 4 of Toilet No. 5 of House No. 2198, Second Floor

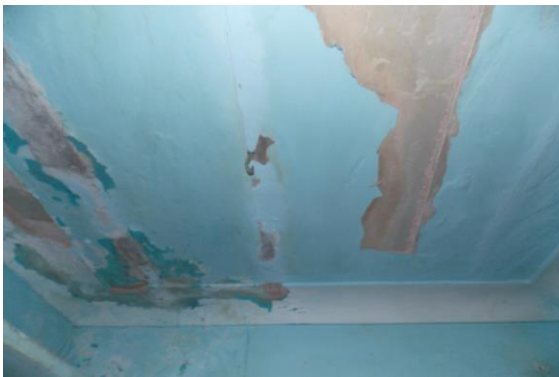
Photo 152

Peeling of Plaster on Wall No. 1 & 4 of Toilet No. 5 of House No. 2198, Second Floor

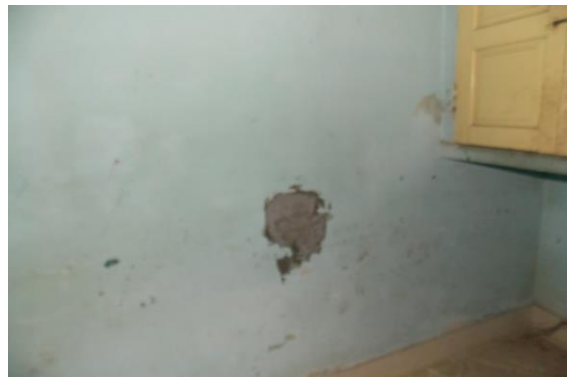
Photo 153

Peeling of Plaster on Roof of Toilet No. 4 of House No. 2198, Second Floor

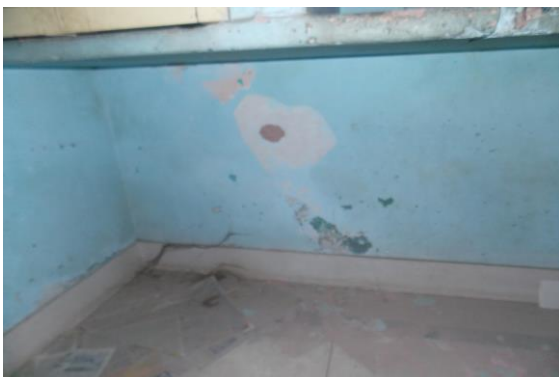
Photo 154

Peeling of Plaster on Wall No. 1 of Toilet No. 4 of House No. 2198, Second Floor

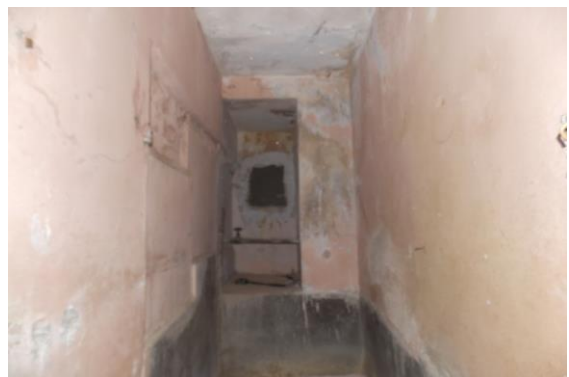
Photo 155

Peeling of Plaster on Wall No. 4 of Toilet No. 4 of House No. 2198, Second Floor

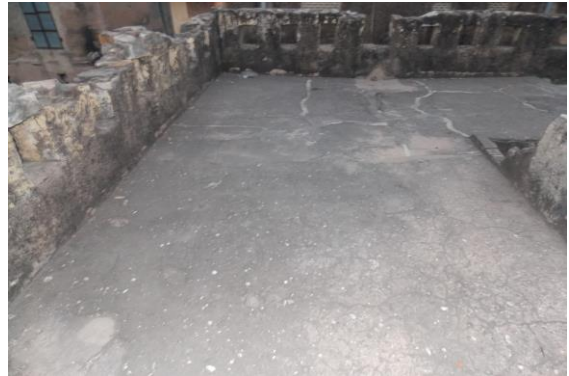
Photo 157

Damaged Portion on All wall of Terrace of House No. 2198, Terrace

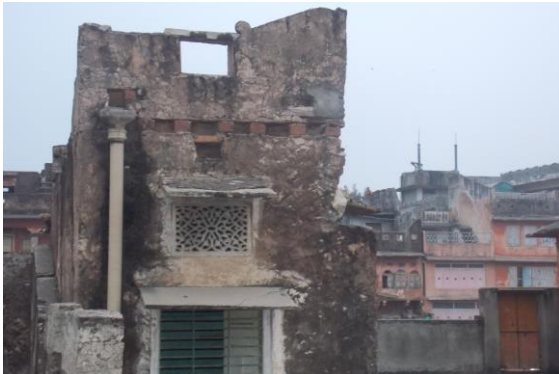
Photo 158

Damaged Portion on All wall of Terrace of House No. 2198, Terrace

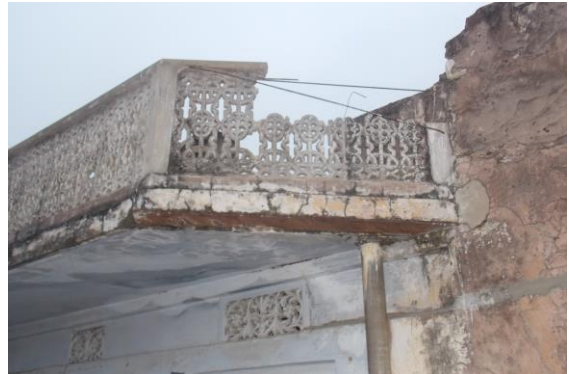
Photo 159

Damaged Portion on All wall of Terrace of House No. 2198, Terrace

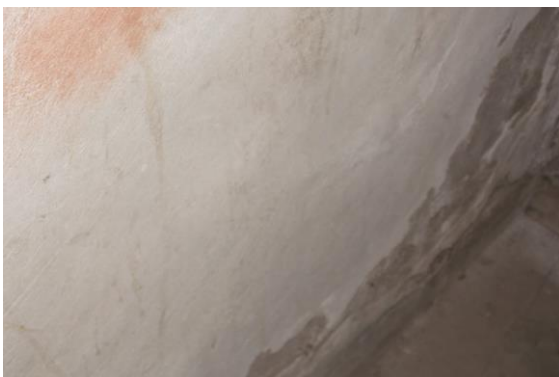
Photo 160

Damaged Portion on Parapit Wall of Terrace of House No. 2198, Terrace

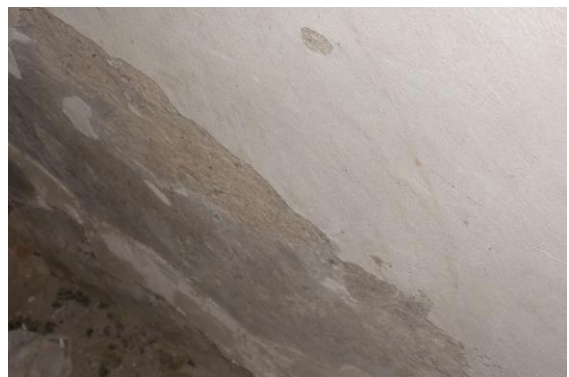
Photo 161

Peeling of Plaster on Wall No. 1 of Passage 1 of House No. 2198, Ground Floor

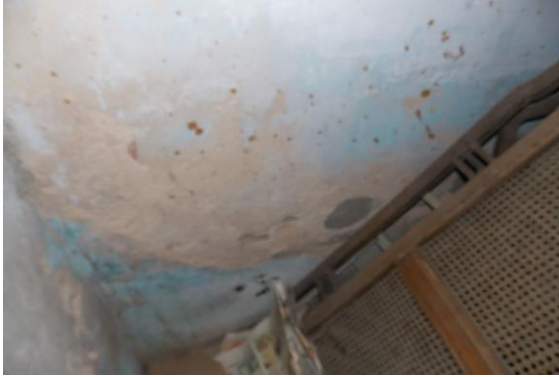
Photo 163

Peeling of Plaster on Wall No. 1 of Hall No. 2 of House No. 2198, Ground Floor

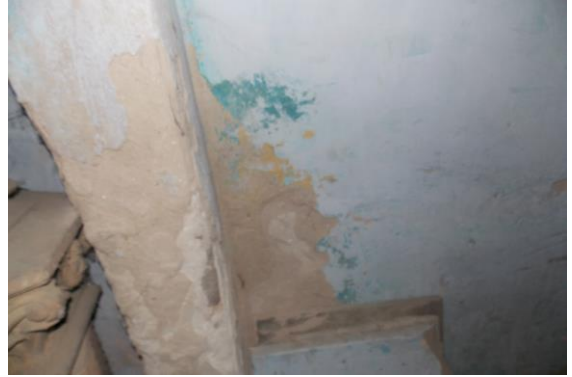
Photo 164

Peeling of Plaster on Wall No. 4 of Hall No. 2 of House No. 2198, Ground Floor

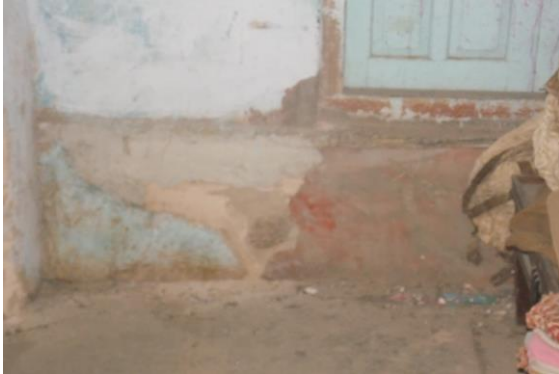
Photo 165

Peeling of Plaster on Wall No. 2 of Hall No. 2 of House No. 2198, Ground Floor

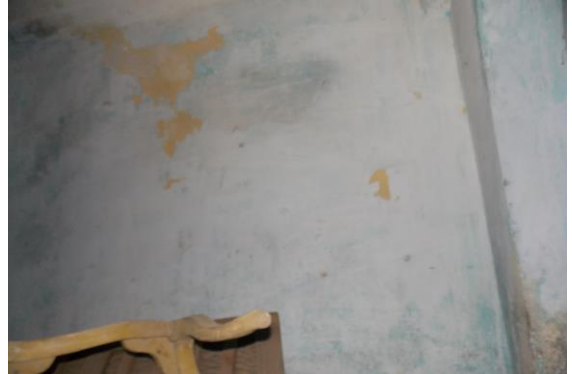
Photo 166

Dampness/Seepage on Wall No. 3 of Hall No. 2 of House No. 2198, Ground Floor

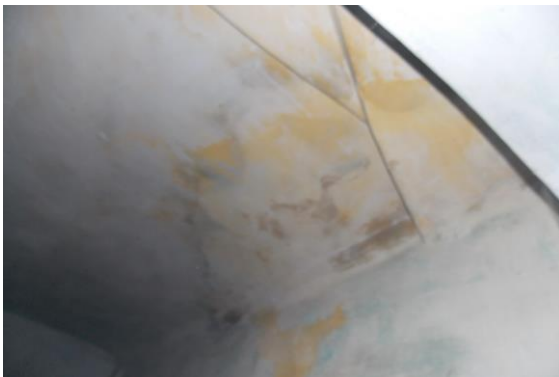
Photo 167

Dampness/Seepage on Roof of Hall No. 2 of House No. 2198, Ground Floor

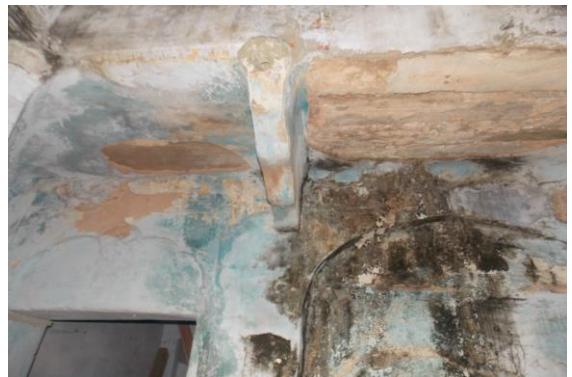
Photo 168

Peeling of Plaster on Wall No. 4 & Sunshade of Open Sky of House No. 2198, Ground Floor

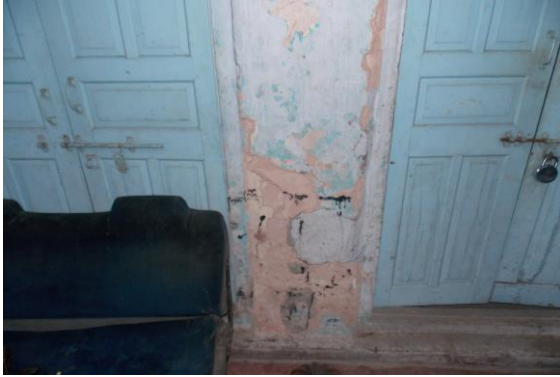
Photo 169

Damaged Portion on Wall No. 1 & Sunshade of Open Sky of House No. 2198, Ground Floor

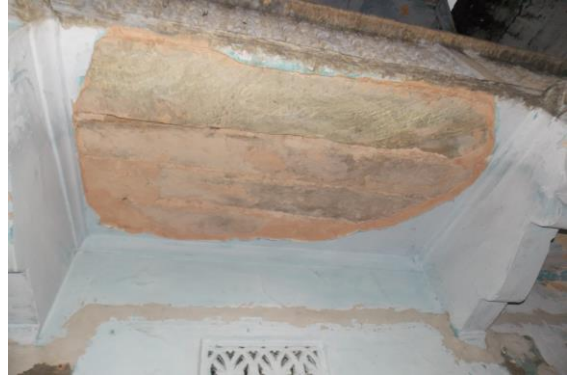
Photo 170

Damaged Portion on Wall No. 1 & Sunshade of Open Sky of House No. 2198, Ground Floor

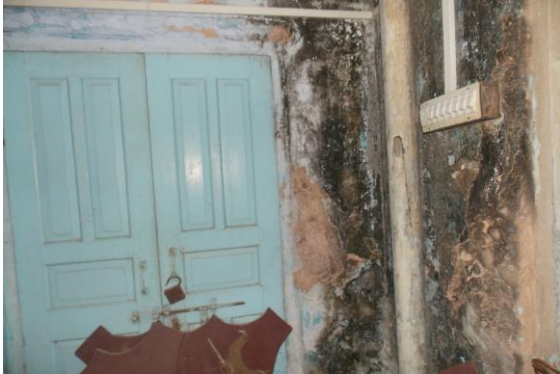
Photo 171

Damaged Portion on Wall No. 3 & Sunshade of Open Sky of House No. 2198, Ground Floor

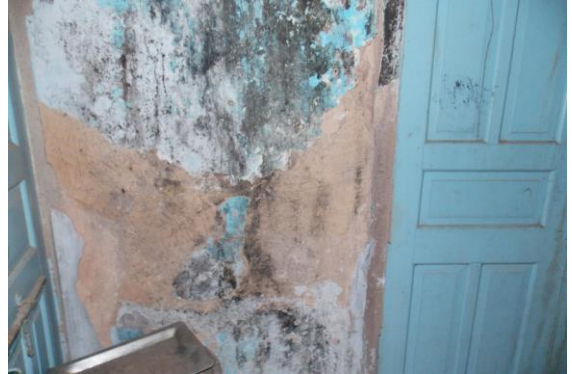
Photo 172

Damaged Portion on Wall No. 3 & Sunshade of Open Sky of House No. 2198, Ground Floor

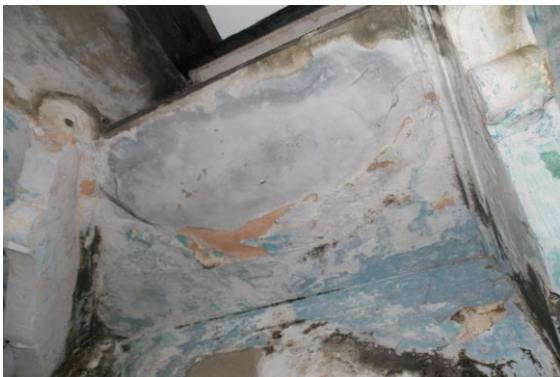
Photo 173

Damaged Portion on Wall No. 2 & Sunshade of Open Sky of House No. 2198, Ground Floor

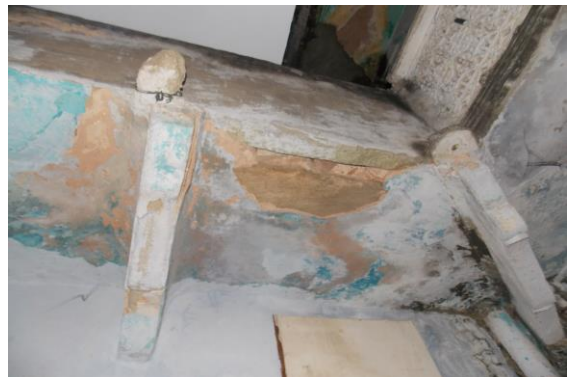
Photo 174

Peeling of Plaster on Wall No. 2 & Sunshade of Open Sky of House No. 2198, Ground Floor

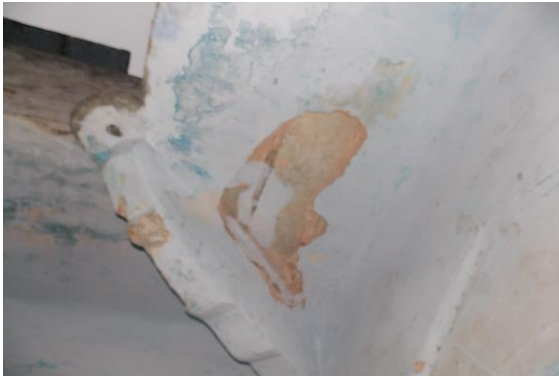
Photo 175

Peeling of Plaster on Wall No. 2 & Sunshade of Open Sky of House No. 2198, Ground Floor

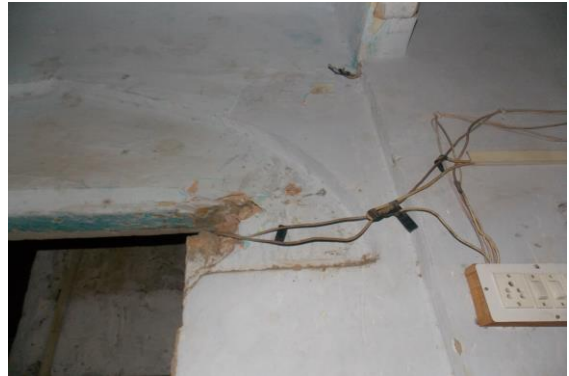
Photo 176

Peeling of Plaster on Wall No. 2 of Open Sky of House No. 2198, Ground Floor

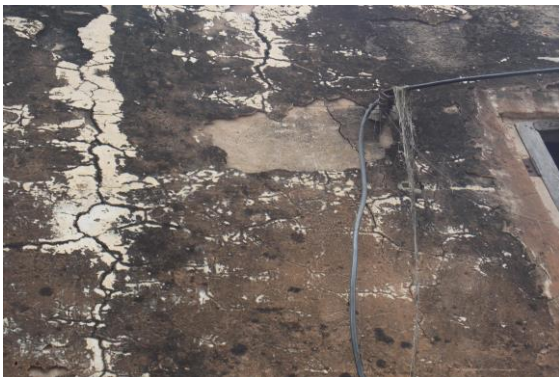
Photo 177

Peeling of Plaster on Back Side Wall of House No. 2198, First Floor

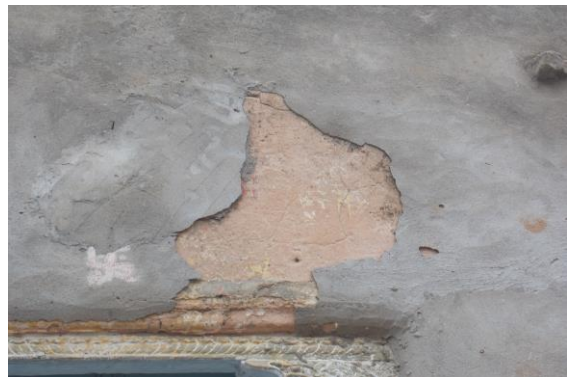
Photo 178

Peeling of Plaster on Back Side Wall of House No. 2198, Ground Floor

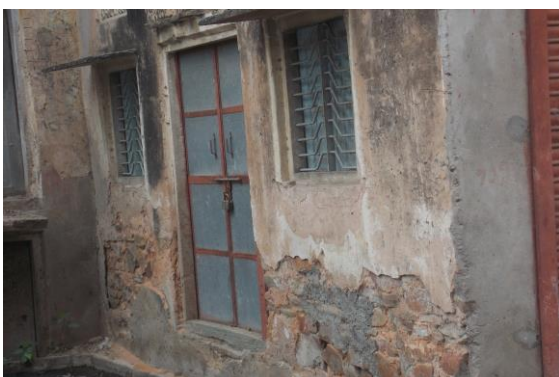
Photo 179

Peeling of Plaster on Back Side Wall of Gate of House No. 2198, Ground Floor

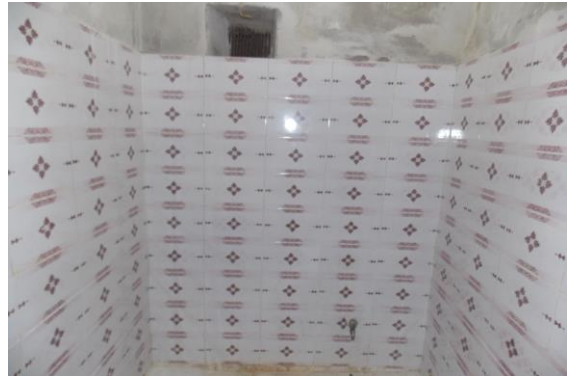
Photo 182  
All wall of Bathroom of House No. 2198, Ground Floor Covered with tiles

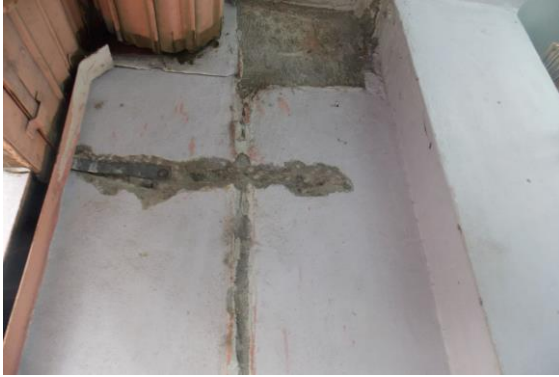
Photo 19  
Peeling of Plaster on Wall No. 1 of Shop No. 5 of Ground Floor

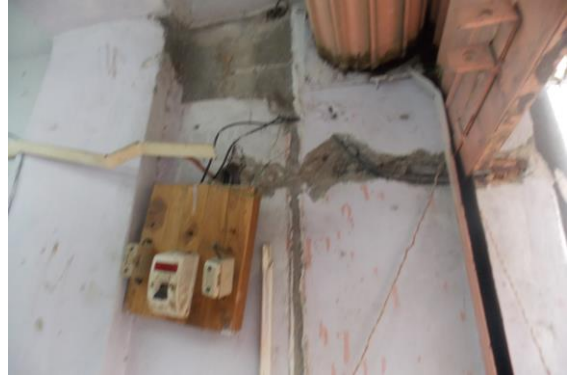
Photo 20  
Peeling of Plaster on Wall No. 2 of Shop No. 5 of Ground Floor

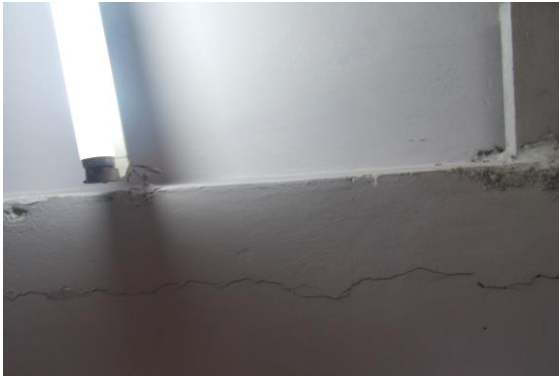
Photo 21  
Peeling of Plaster on Roof of Part B of Shop No. 4, Ground Floor

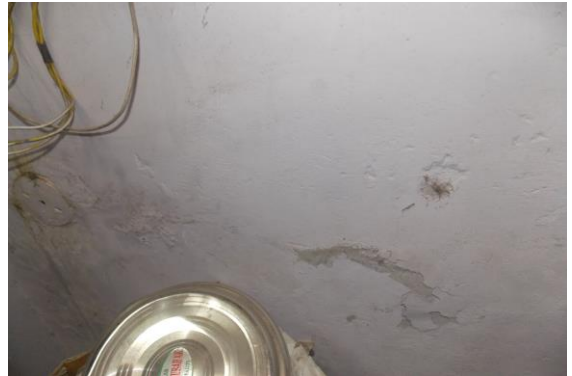
Photo 22  
Peeling of Plaster on Wall No. 2 of Stair Gf To Basement of Shop No. 4, Ground Floor

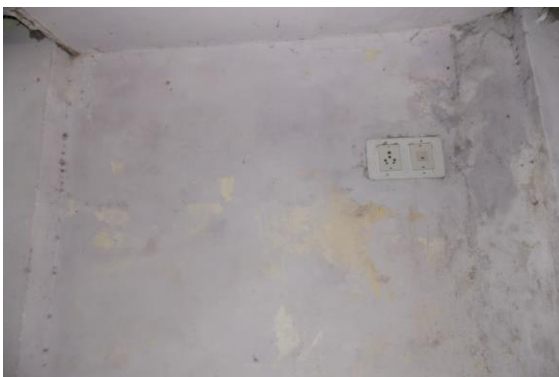
Photo 23  
Peeling of Plaster on Wall No. 2 of Basement of Shop No. 4, Basement
