### Pre Building Condition Survey Report

Name and Address of Structure :	Badi Chopar to Ramp Area (UP Line)
---------------------------------	------------------------------------

Name of the Project	<b>Contract JMRC-UG1B</b> “Design and Construction of Tunnel between Chandpole and Badi Chouper and reverse line by Shield TBM, Underground Metro Stations at Choti Chouper and Badi Chouper by Cut and Cover Methods on East West Corridor of Jaipur Metro Rail Corporation Limited .”	
Owner :

Pre Building Condition Survey Report Badi Chopar to Ramp Area (UP Line)

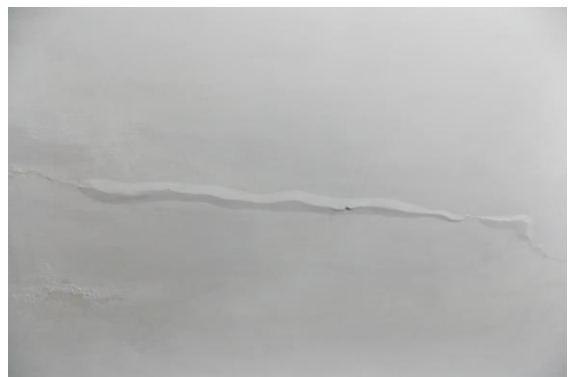
Photo 24  
Peeling of Plaster on Roof of Shop No. 10, Upper Ground Floor

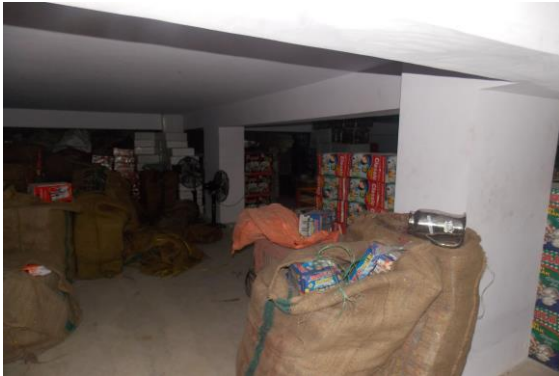
Photo 25

Peeling of Plaster on All Walls of Shop No. 10, Upper Ground Floor

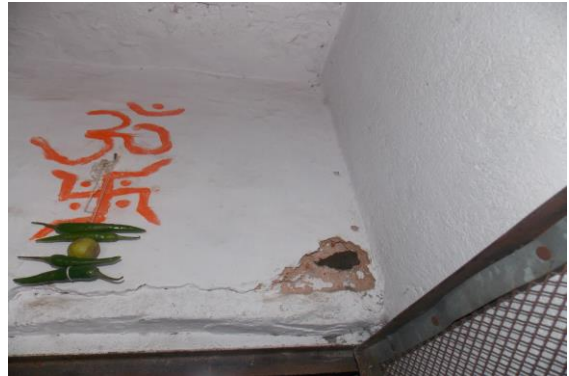
Photo 26

Peeling of Plaster on Outer Wall of Gate of Shop No. 8, Ground Floor

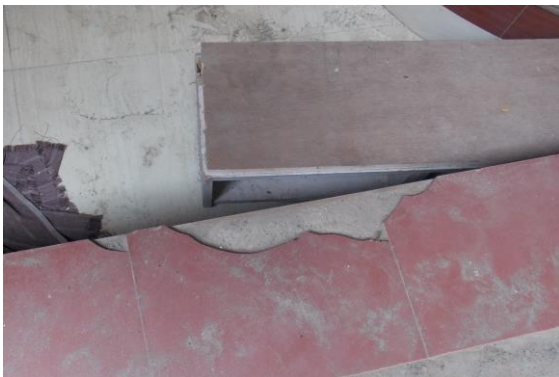
Photo 27

Peeling of Plaster on of Entry Gate of Shop No. 9, Ground Floor

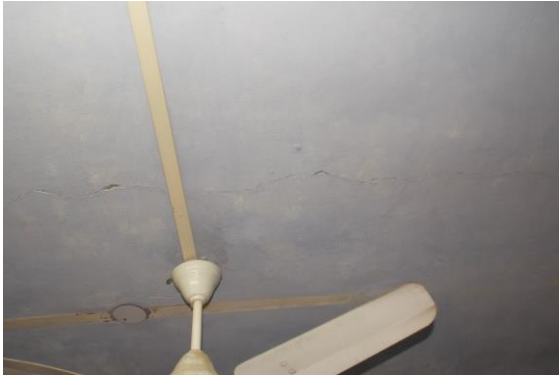
Photo 7

Horizontal Crack on Roof of Shop No. SF 01, Ground Floor  
Approx. Width = 1mm, Approx. Length = 2.7m.  
Distance from Wall No. 1 = 1.3m, Height from Floor = 2.5m.

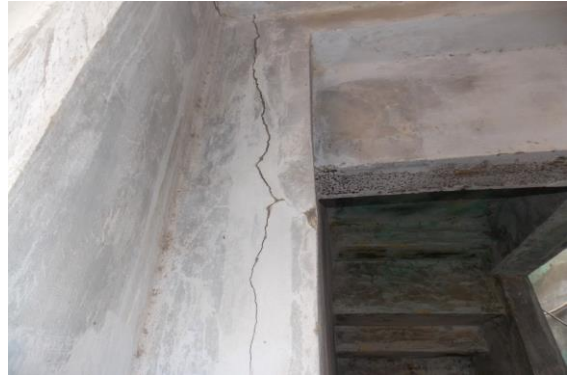
Photo 8

Inclined Crack on Wall No. 3 of Balcony, Shop No. SF 03 Second Floor  
Approx. Width = 4mm, Approx. Length = 1.2m.  
Distance from Wall No. 2 = 0.15m, Height from Floor = 1.7m.

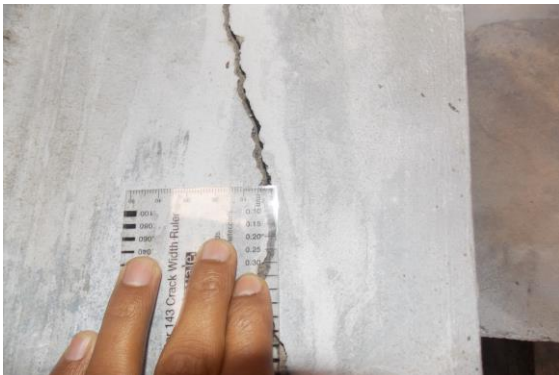
Photo 8A

Inclined Crack on Wall No. 3 of Balcony, Shop No. SF 03 Second Floor  
Approx. Width = 4mm, Approx. Length = 1.2m.  
Distance from Wall No. 2 = 0.15m, Height from Floor = 1.7m.

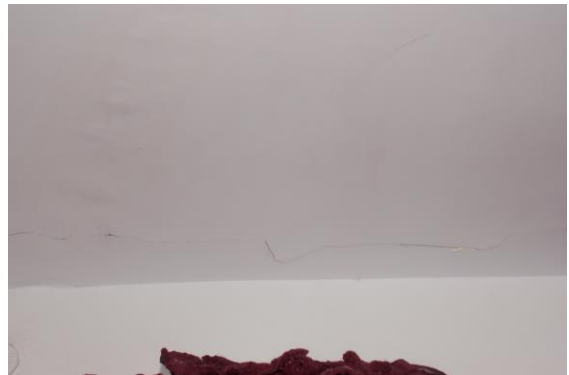
Photo 9

Inclined Crack on Roof of Part B, Shop No. FF 01 First Floor Part B  
Approx. Width = 2.5mm, Approx. Length = 3.5m.  
Distance from Wall No. 2 = 0.15m, Height from Floor = 3m.

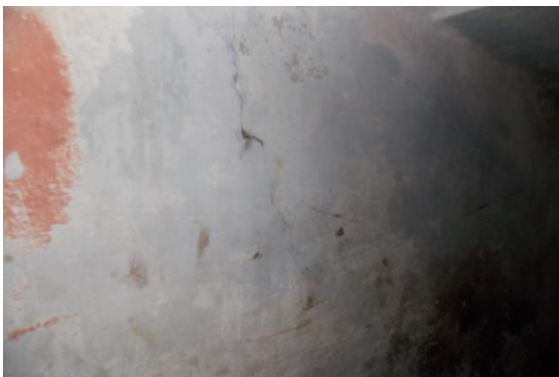
Photo 10

Inclined Crack on of Stair GF to FF,  
Approx. Width = 0.25mm, Approx. Length = 0.9m.  
Distance from Wall No. 4 = 0.6m, Height from Floor = 1m.

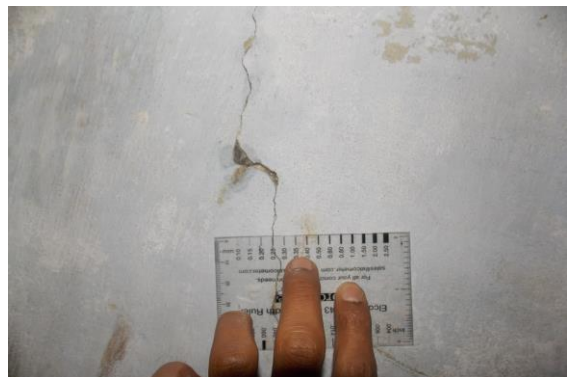
Photo 10A

Inclined Crack on of Stair GF to FF,  
Approx. Width = 0.25mm, Approx. Length = 0.9m.  
Distance from Wall No. 4 = 0.6m, Height from Floor = 1m.

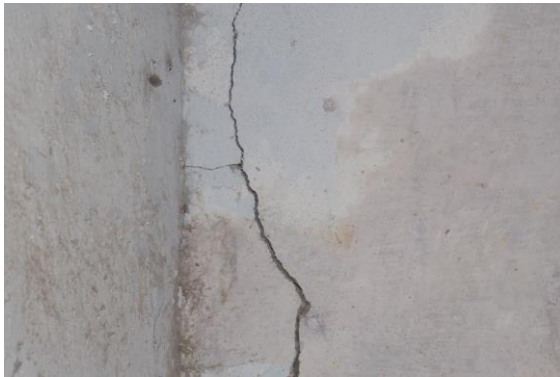
Photo 11

Inclined Crack on Wall No. 4 of Stair GF to FF,  
Approx. Width = 1.5mm, Approx. Length = 0.5m.  
Distance from Wall No. 1 = 0m, Height from Floor = 2.1m.

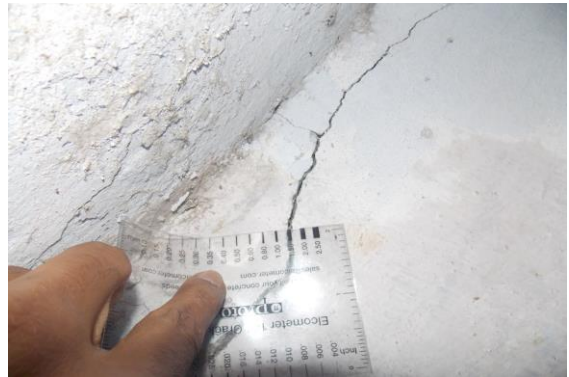
Photo 11A

Inclined Crack on Wall No. 4 of Stair GF to FF,  
Approx. Width = 1.5mm, Approx. Length = 0.5m.  
Distance from Wall No. 1 = 0m, Height from Floor = 2.1m.

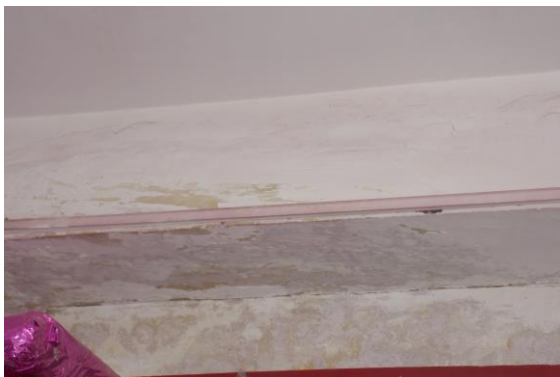
Photo 14

Dampness/Seepage on Wall No. 4 of Part B of Shop No. FF 01 First Floor Part B

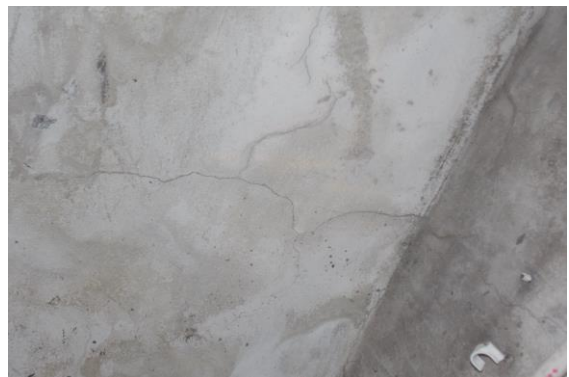
Photo 15

Peeling of Plaster on Wall No. 3 & Roof of Balcony of 0031/ff-sf

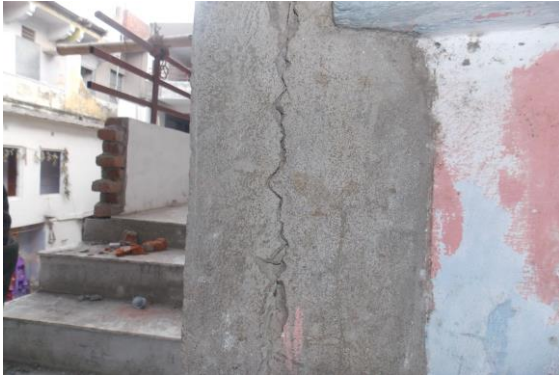
Photo 16  
Damaged Portion on Wall No. 2

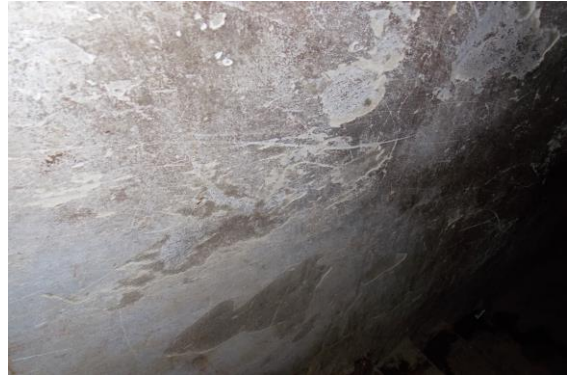
Photo 17  
Peeling of Plaster on Wall No. 1 of Stair GF to FF

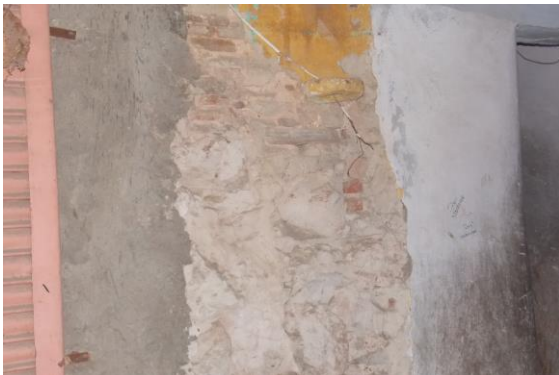
Photo 18  
Peeling of Plaster on Left Side Wall of of Ground Floor

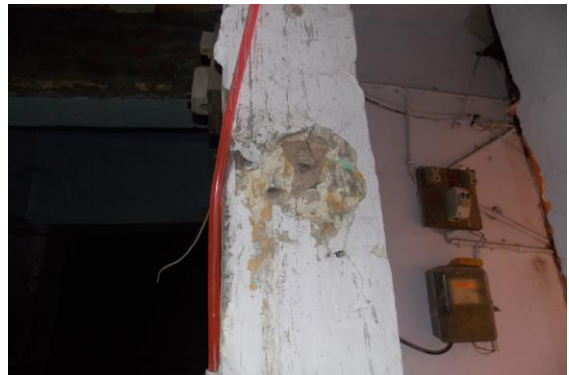
Photo 19  
Peeling of Plaster on Fornt Wall of of Ground Floor

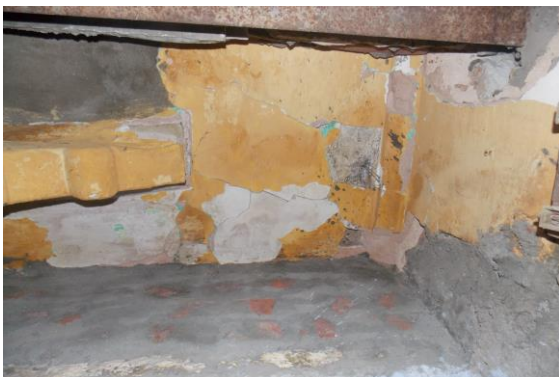
Photo 20  
Damaged Portion on of Ground Floor

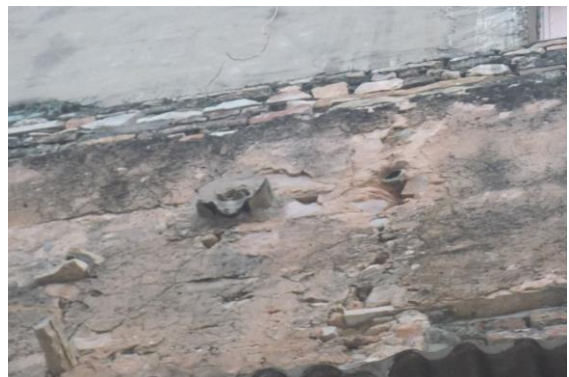
Photo 21  
Peeling of Plaster on Back Side Wall of of First Floor

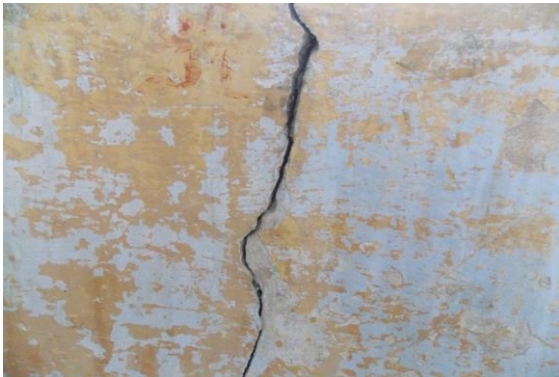
Photo 7

Inclined Crack on Wall No. 4 of House No. 1908 Second Floor  
Approx. Width = 2.5mm, Approx. Length = 1.6m.  
Distance from w1 = 2.5m, Height from Floor = 0m.

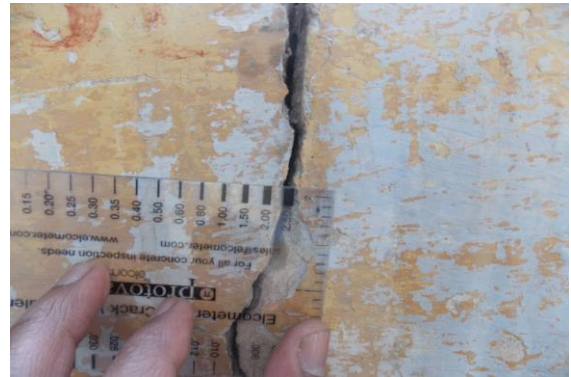
Photo 7A

Inclined Crack on Wall No. 4 of House No. 1908 Second Floor  
Approx. Width = 2.5mm, Approx. Length = 1.6m.  
Distance from w1 = 2.5m, Height from Floor = 0m.

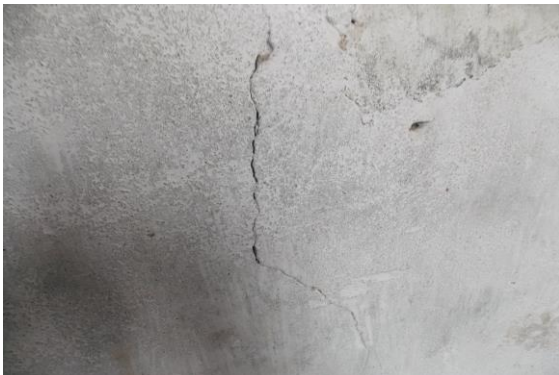
Photo 8

Inclined Crack on Wall No. 4 of House No. 1908 Second Floor  
Approx. Width = 1mm, Approx. Length = 1.3m.  
Distance from w1 = 0.85m, Height from Floor = 0m.

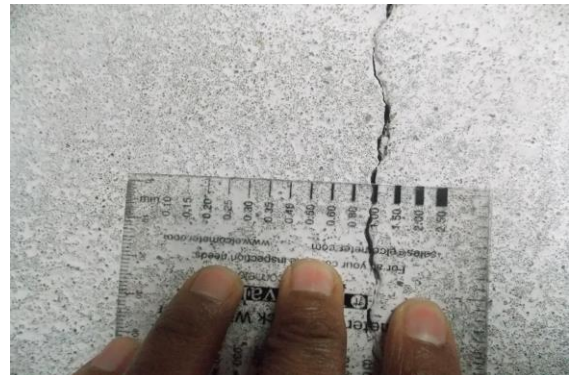
Photo 8A

Inclined Crack on Wall No. 4 of House No. 1908 Second Floor  
Approx. Width = 1mm, Approx. Length = 1.3m.  
Distance from w1 = 0.85m, Height from Floor = 0m.

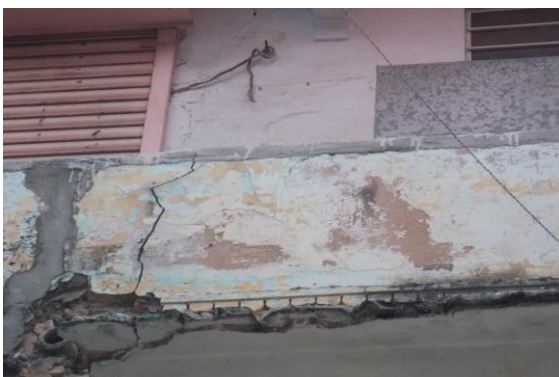
Photo 9

Inclined Crack on Parapet Wall of Second Floor  
Approx. Width = 0.4mm, Approx. Length = 1m.  
Distance from left wall = 3.3m, Height from Floor = 0.7m.

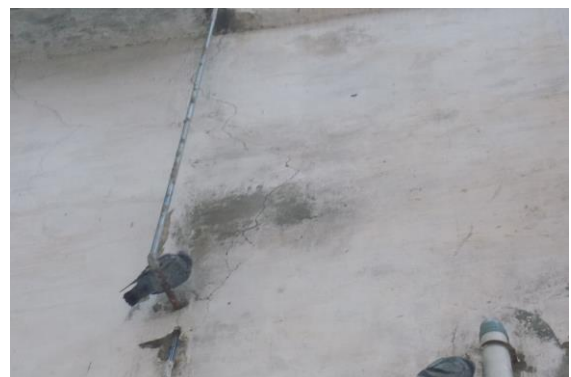
Photo 10

Inclined Crack on Back Wall of Ground Floor  
Approx. Width = 4mm, Approx. Length = 8m.  
Distance from right wall = 4.5m, Height from Floor = 7m.

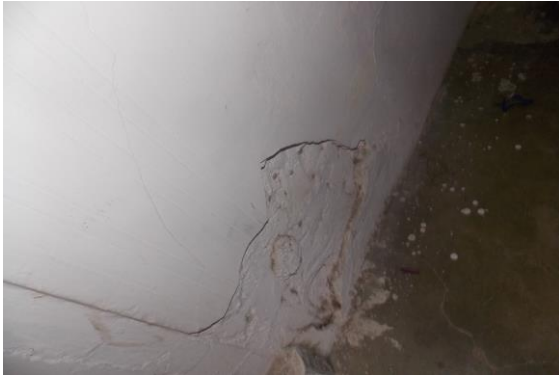
Photo 11

Peeling of Plaster on Wall No. 3 of Balcony of House No. 1908 First Floor

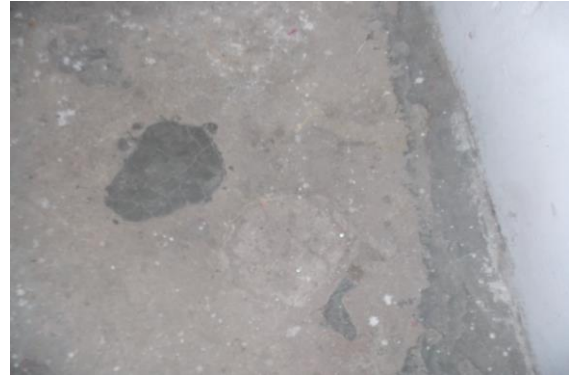
Photo 12

Peeling of Plaster on Floor of Balcony of House No. 1908 First Floor

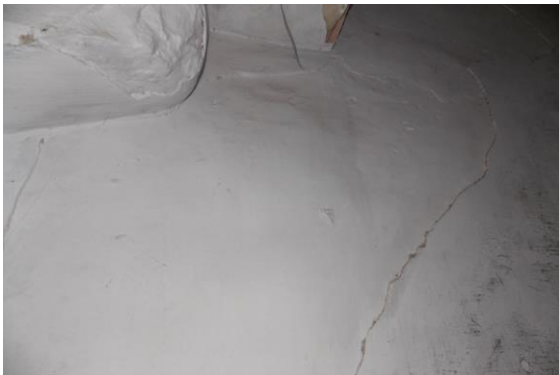
Photo 13

Peeling of Plaster on Wall No. 1 of Stair FF to SF of House No. 1908 First Floor

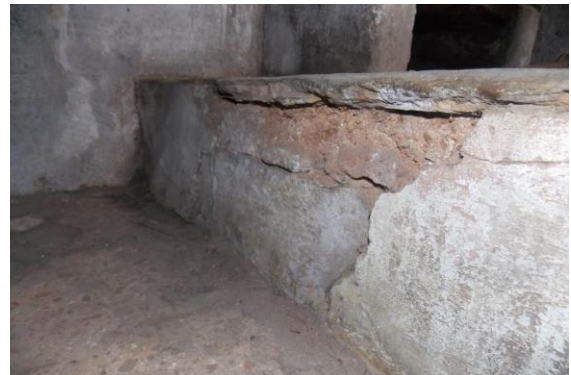
Photo 14

Peeling of Plaster on Wall No. 2 of House No. 1908 First Floor

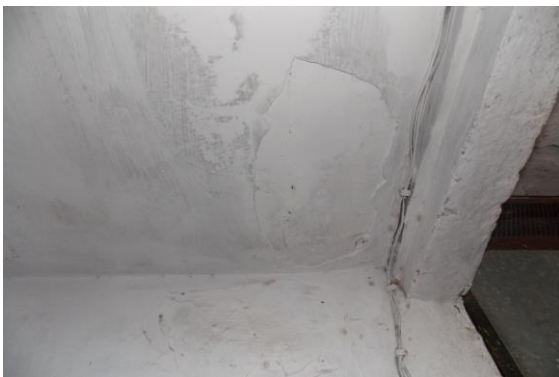
Photo 15

Peeling of Plaster on Roof of House No. 1908 First Floor

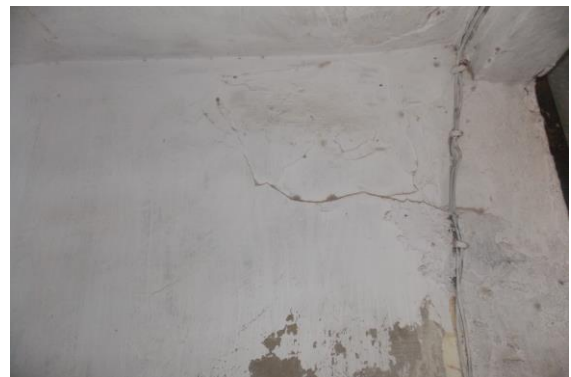
Photo 16

Peeling of Plaster on Wall No. 4 of House No. 1908 First Floor

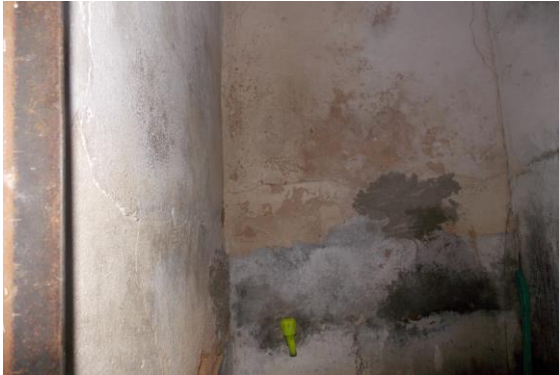
Photo 17

Peeling of Plaster on Wall No. 4 & 1 of Toilet No. 1 of House No. 1908 First Floor

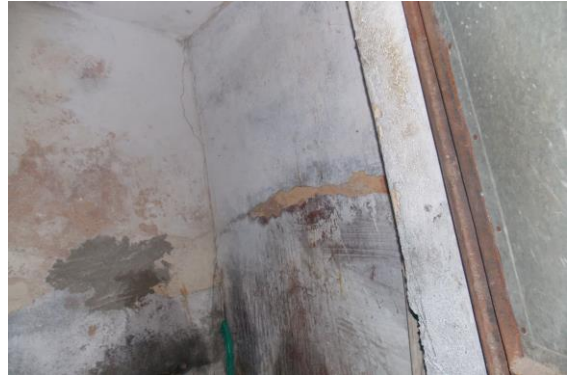
Photo 18

Peeling of Plaster on Wall No. 2 of Toilet No. 1 of House No. 1908 First Floor

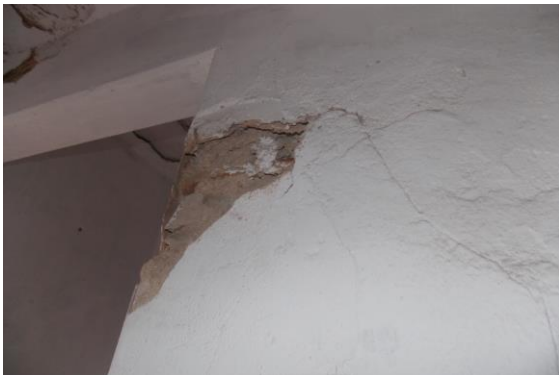
Photo 19

Peeling of Plaster on Wall No. 2 of Stair FF to SF of House No. 1908 First Floor

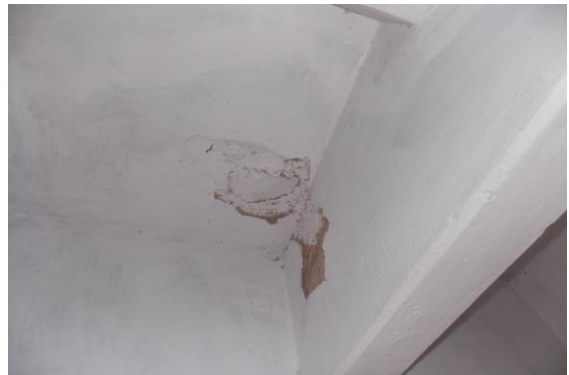
Photo 20

Peeling of Plaster on Wall No. 2 & Roof of Stair FF to SF of House No. 1908 First Floor

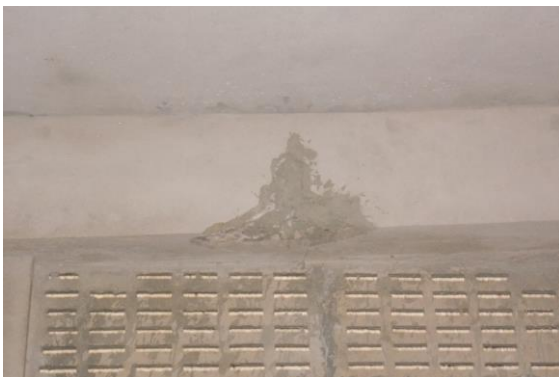
Photo 21

Peeling of Plaster on Wall No. 4 of Room No. 1 of House No. 1908 Second Floor

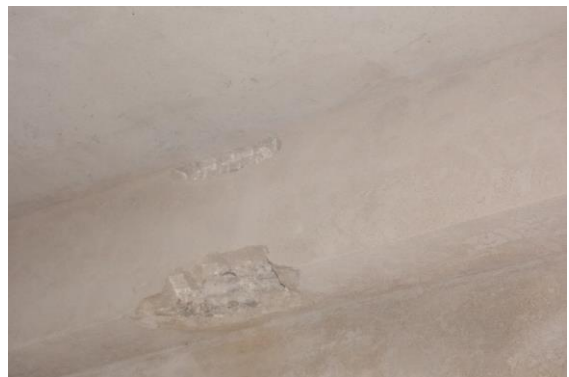
Photo 22

Peeling of Plaster on Wall No. 2 of House No. 1908 Second Floor

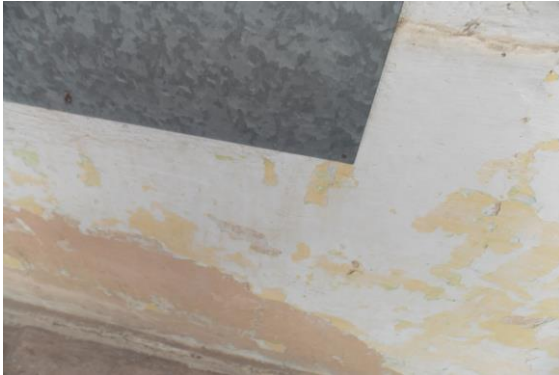
Photo 23

Peeling of Plaster on Wall No. 3 of Balcony of House No. 1908 Second Floor

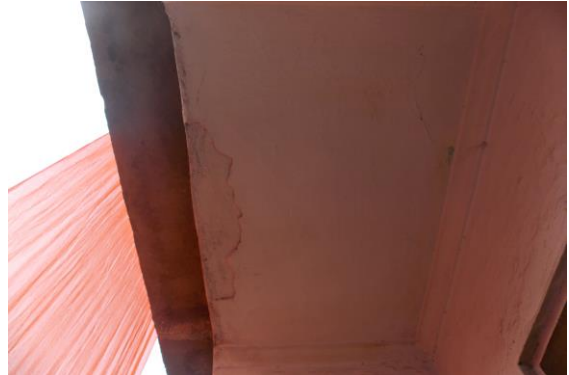
Photo 24

Peeling of Plaster on Roof of House No. 1908 Second Floor

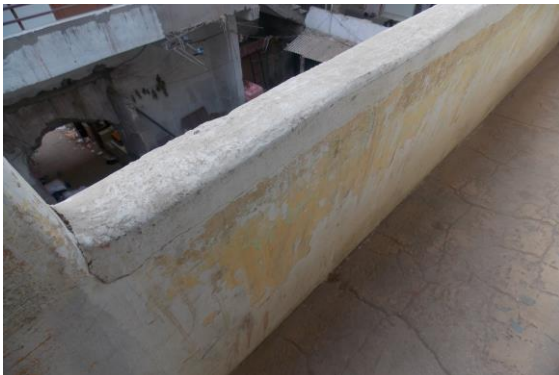
Photo 25

Peeling of Plaster on Wall No. 4 of House No. 1908 Second Floor

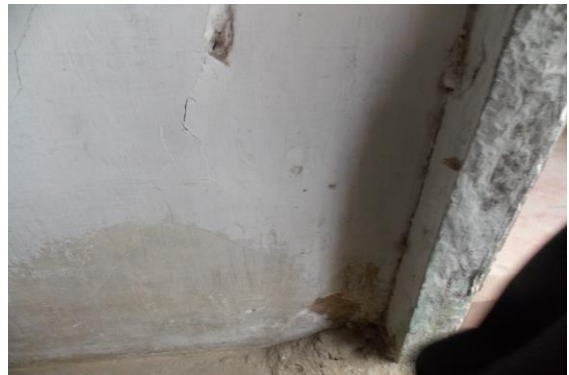
Photo 26

Peeling of Plaster on Wall No. 1 of Stair SF to TF of House No. 1908 Second Floor

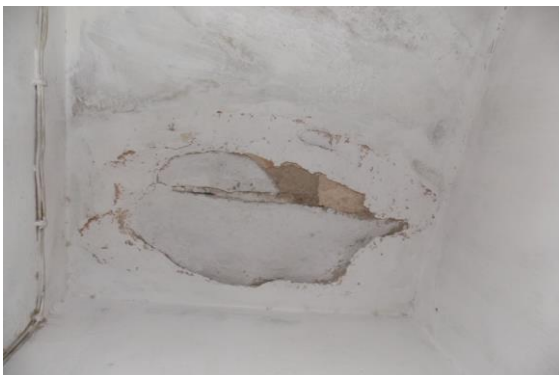
Photo 27

Peeling of Plaster on Roof of House No. 1908 Second Floor

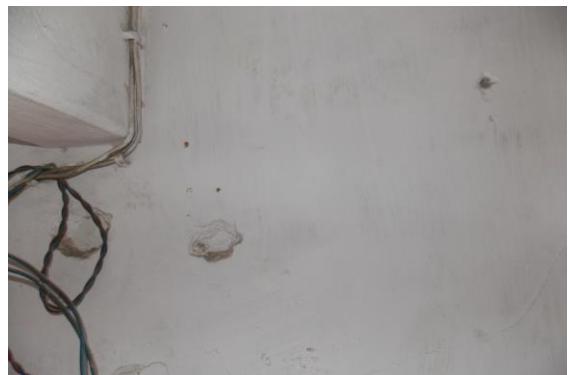
Photo 28

Peeling of Plaster on Wall No. 3 of House No. 1908 Second Floor

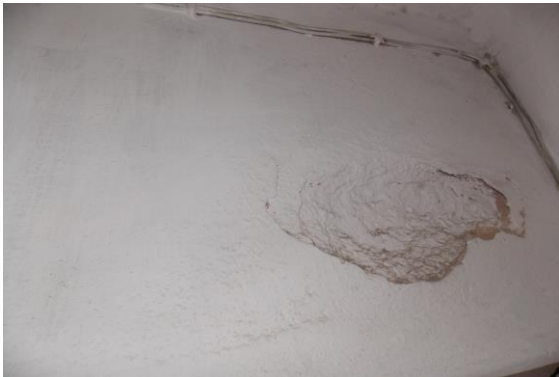
Photo 29

Peeling of Plaster on Wall No. 2 of House No. 1908 Second Floor

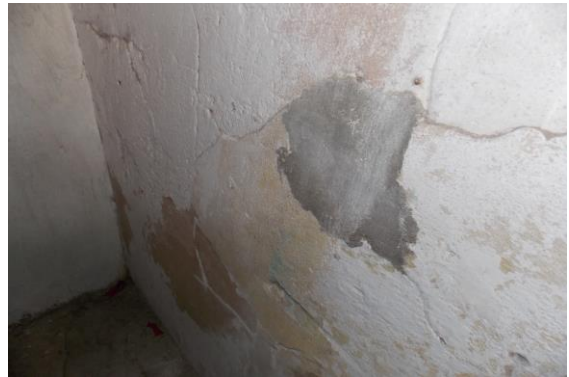
Photo 30

Peeling of Plaster on Wall No. 2 of House No. 1908 Second Floor

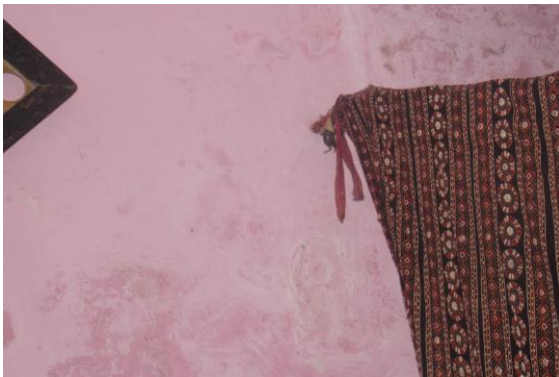
Photo 31

Dampness/Seepage on Wall No. 1 of Room No. 1 of House No. 1908 Second Floor

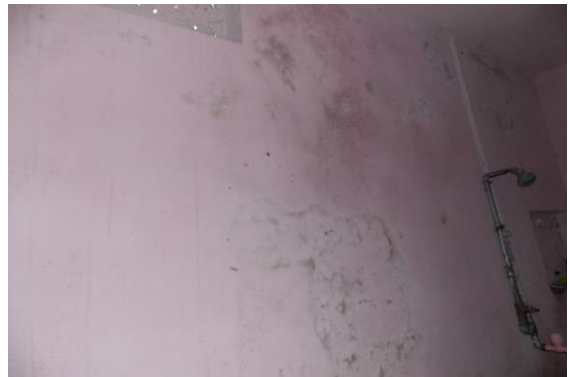
Photo 32

Dampness/Seepage on Wall No. 4 of Room No. 1 of House No. 1908 Second Floor

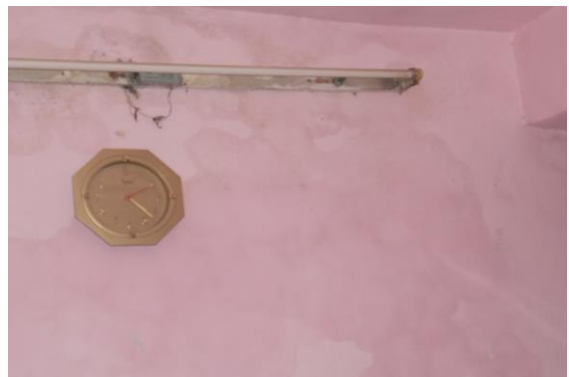
Photo 34

Dampness/Seepage on Wall No. 1 of Room No. 2 of House No. 1908 Second Floor

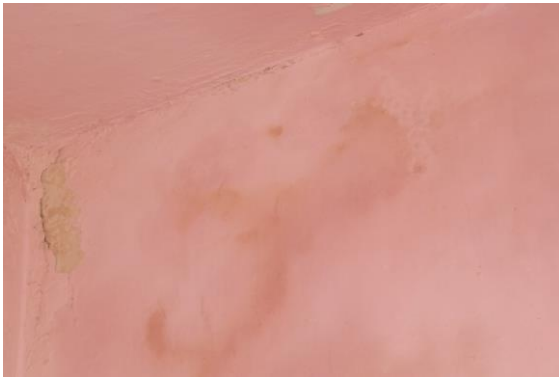
Photo 35  
Dampness/Seepage on Wall No. 4 of Kitchen of House No. 1908  
Second Floor

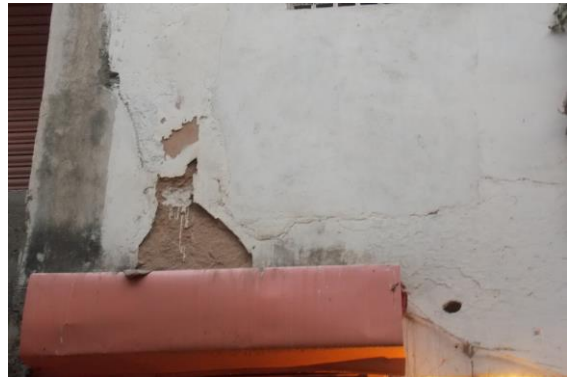
Photo 36  
Peeling of Plaster on House No. 1908 Second Floor

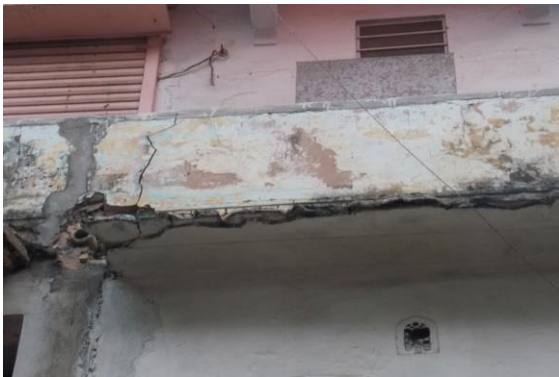
31	Shed First Floor	Damaged Portion	37
32	Front Wall Ground Floor	Peeling of Plaster	38
33	Back Wall Ground Floor	Peeling of Plaster	39
34	Wall No. 4 Balcony Shop No. SF 01 Second Floor	Peeling of Plaster	40

Photo 37  
Damaged Portion on Shed of First Floor

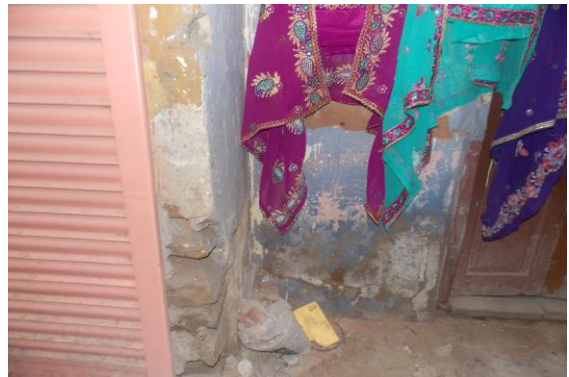
Photo 38  
Peeling of Plaster on Front Wall of Ground Floor

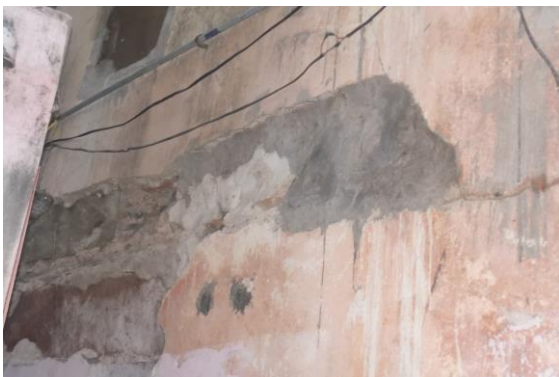
Photo 39  
Peeling of Plaster on Back Wall of of Ground Floor

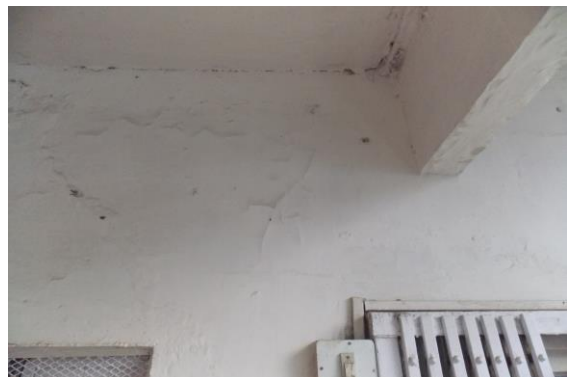
Photo 40  
Peeling of Plaster on Wall No. 4 of Balcony of Shop No. SF 01 Second  
Floor

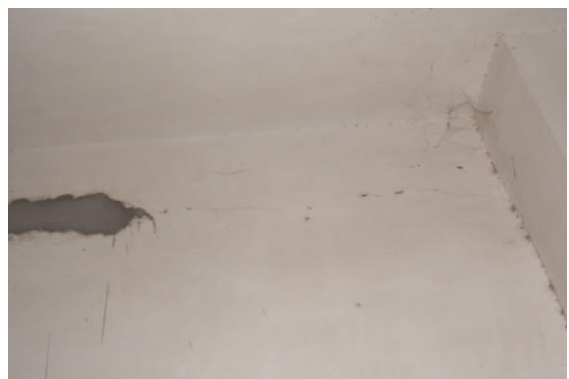
Photo 18

Peeling of Plaster on Wall No. 2 of Room No. 1 of House No. 1907 & 1908 First Floor

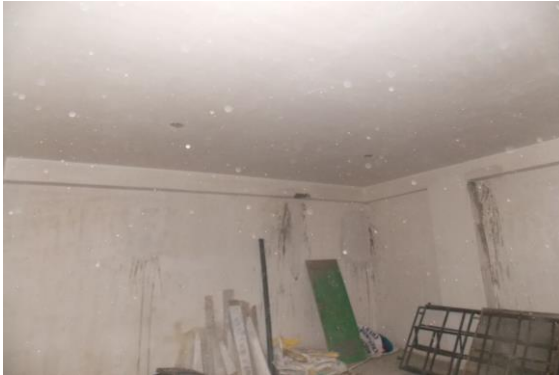
Photo 19

Peeling of Plaster on Hall No. 1 of House No. 1907 & 1908 First Floor

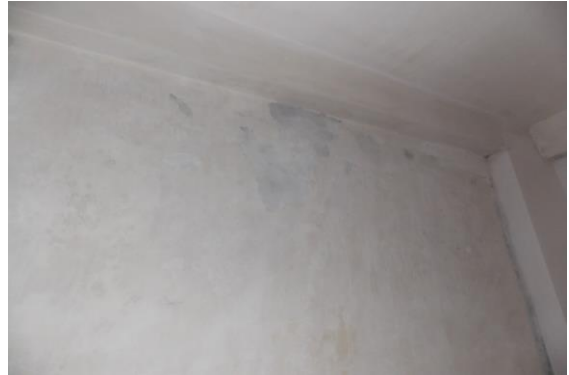
Photo 20

Peeling of Plaster on Wall No. 1 of Room No. 3 of House No. 1907 & 1908 First Floor

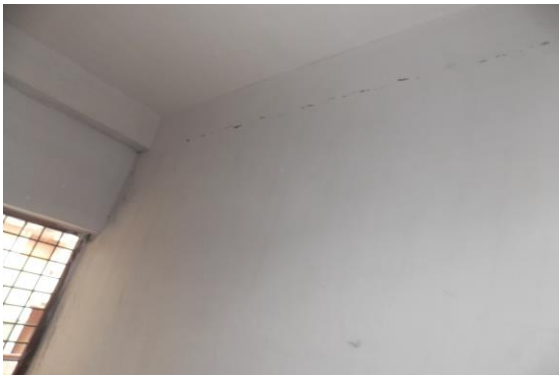
Photo 21

Peeling of Plaster on Wall No. 2 of Room No. 3 of House No. 1907 & 1908 First Floor

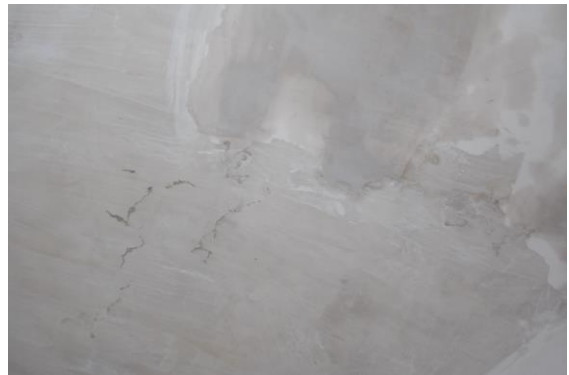
Photo 22

Peeling of Plaster on Roof of Room No. 4 of House No. 1907 & 1908 First Floor

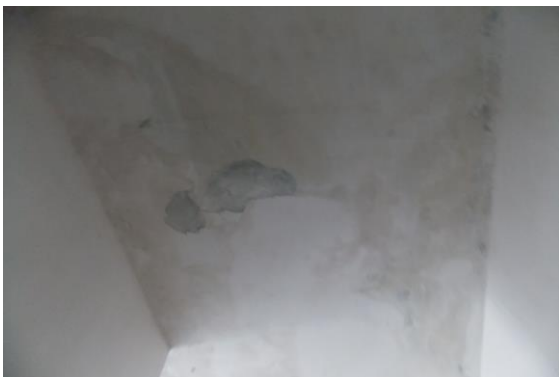
Photo 23

Peeling of Plaster on Roof of Passage of House No. 1907 & 1908 First Floor

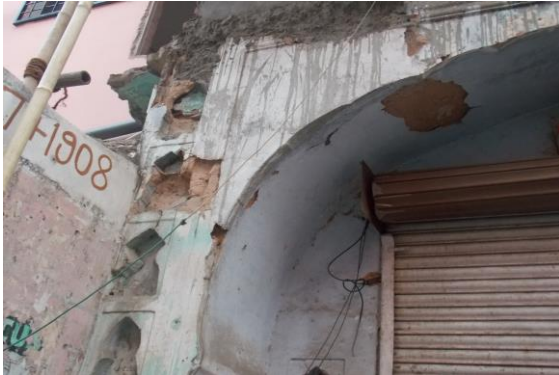
Photo 25

Peeling of Plaster on Gate Lhs of House No. 1907 & 1908 Second Floor

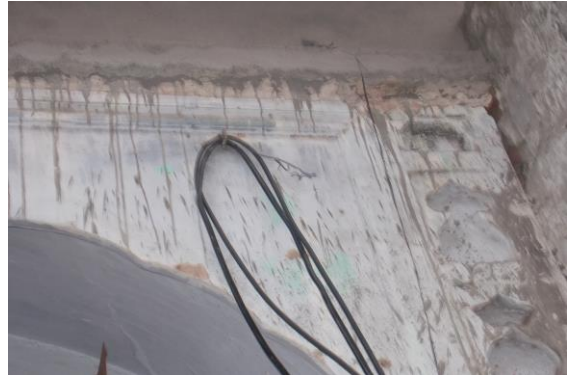
Photo 26

Peeling of Plaster on Gate Rhs of House No. 1907 & 1908 Second Floor

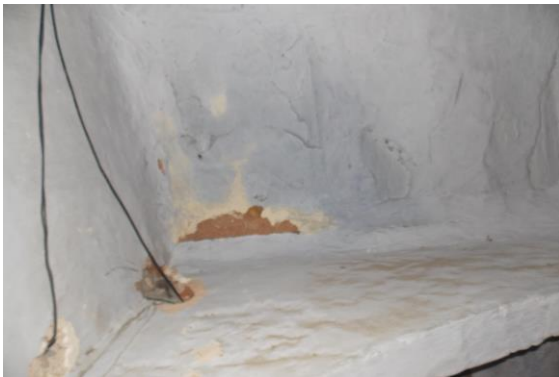
Photo 27

Peeling of Plaster on Roof of House No. 1907 & 1908 Second Floor

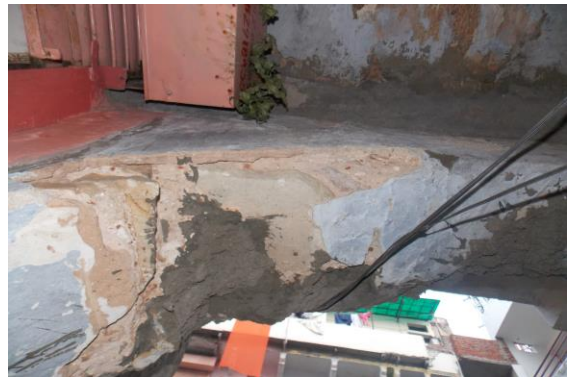
Photo 28

Peeling of Plaster on Roof of House No. 1907 & 1908 Second Floor

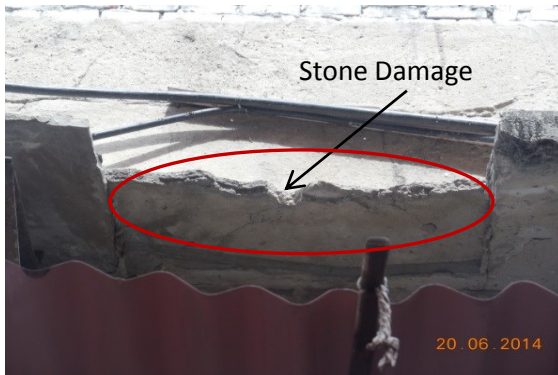
Photo 1

Stone Damage on Outer Wall of Shop No. 5RS, Ground floor

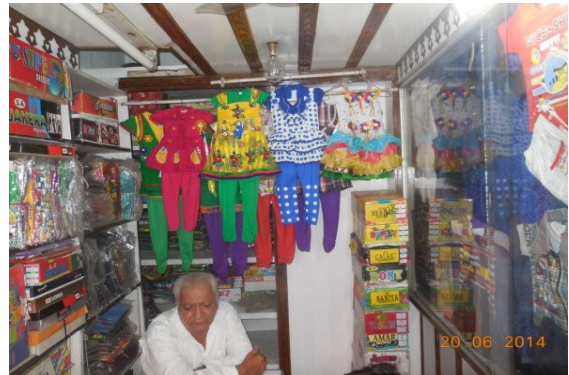
Photo 2

Covered with Materials, All Walls of Shop No. 5RS, Ground floor

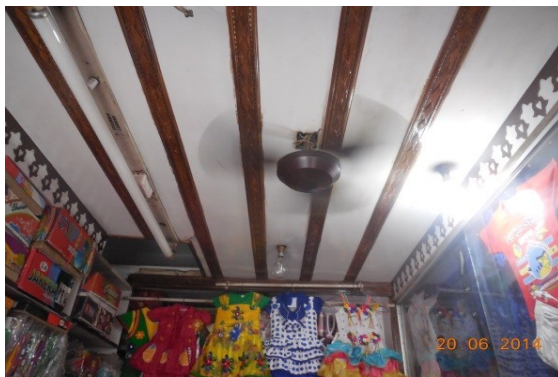
Photo 3

Covered with wooden Ceiling, Roof of Shop No. 5RS, Ground floor

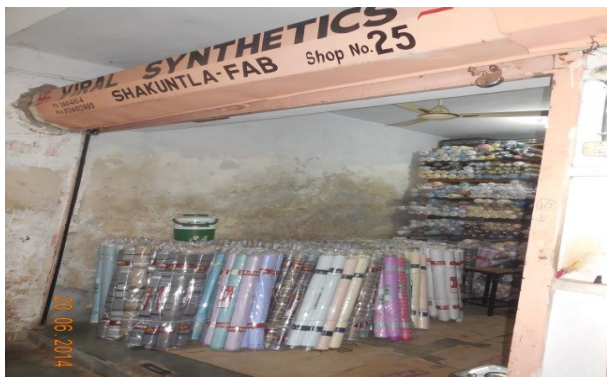
Photo 1

Main View of Shop No. 25, Viral Synthetic, Basement

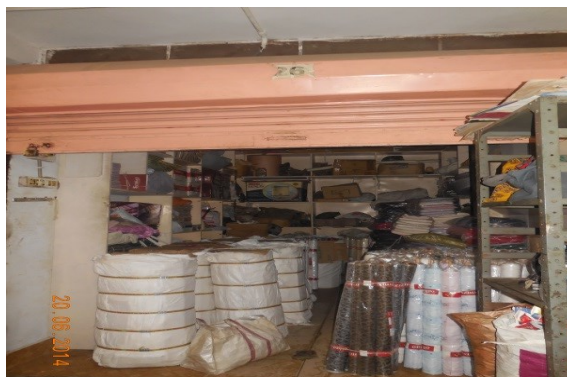
Photo 2

Main View of Shop No. 26, Radhalaxmi Enterprises, Basement

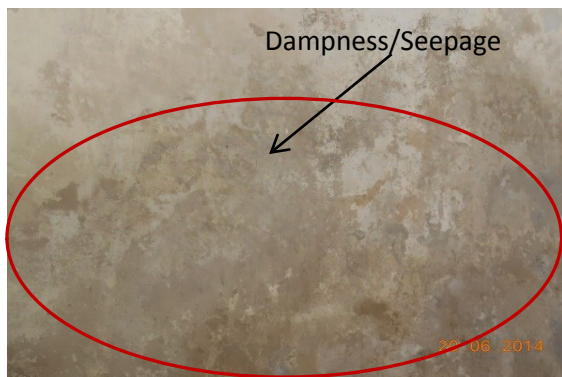
Photo 3

Dampness/Seepage on Wall No.1 of Shop No. 25, Viral Synthetic, Basement

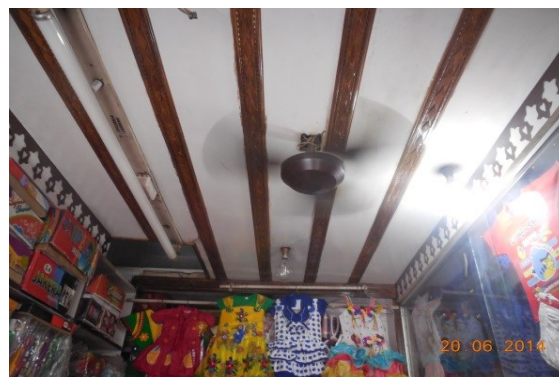
Photo 4

Covered with Materials, Wall No. 4 of Shop No. 25, Viral Synthetic, Basement

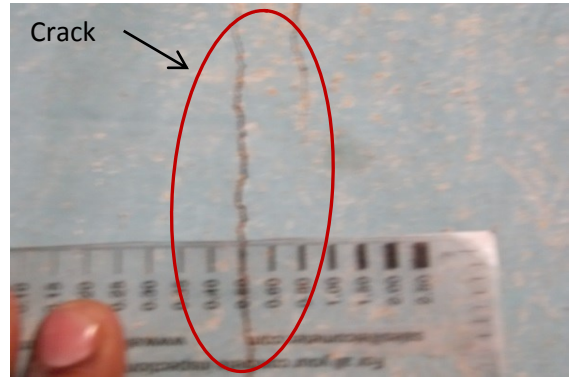
Photo 1B

Vertical Crack on Wall No. 2 of Part-B of Shop No.330, (G.F.)  
Approx. Width = 0.50mm, Approx. Length = 2.00m.  
Distance from Wall No. 3 = 0.60m, Height from Floor = 1.0m.

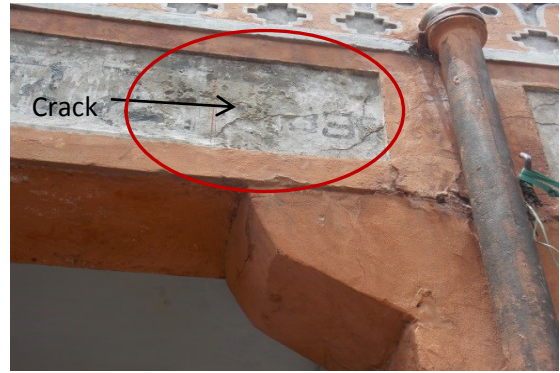
Photo 4B

Inclined Crack on Right Side Column of Varandah of Shop No.330, Ground floor Approx. Width = 0.80mm, Approx. Length = 1.20m. Distance from R.H. Column = 0.00m, Height from Floor = 2.50m.

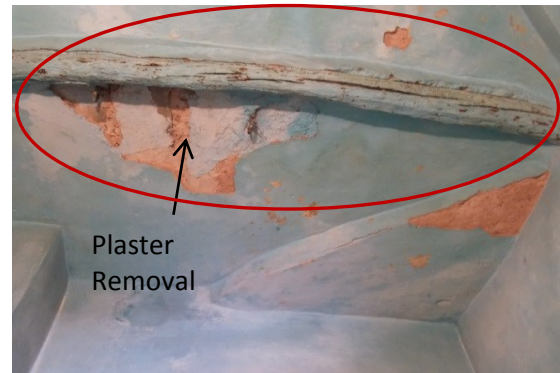
Photo 6

Plaster Removal on Roof of Part-B of Shop No. 330, Ground floor

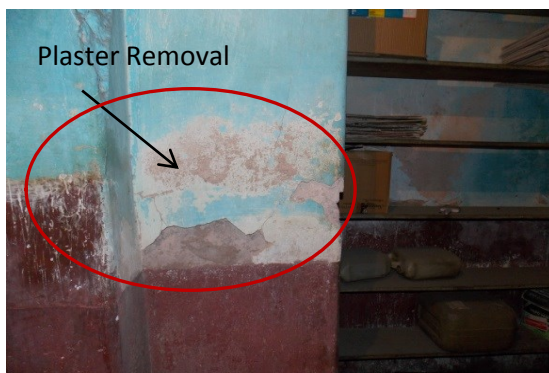
Photo 7A

Plaster Removal on Wall No. 1 of Part-B of Shop No. 330, Ground floor

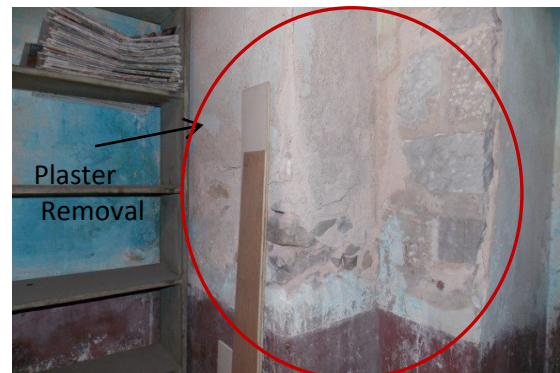
Photo 7B

Plaster Removal on Wall No. 1 of Part-B of Shop No. 330, Ground floor

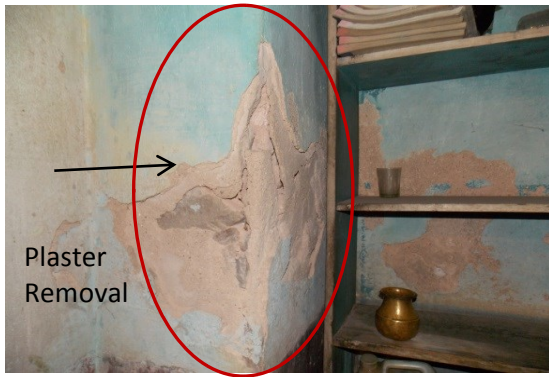
Photo 8A

Plaster Removal on Wall No. 4 of Part-B of Shop No. 330, Ground floor

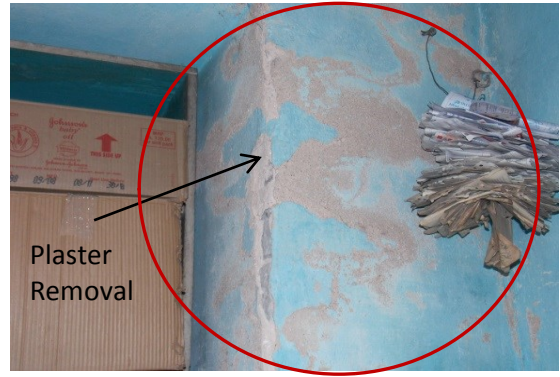
Photo 8B

Plaster Removal on Wall No. 4 of Part-B of Shop No. 330, Ground floor

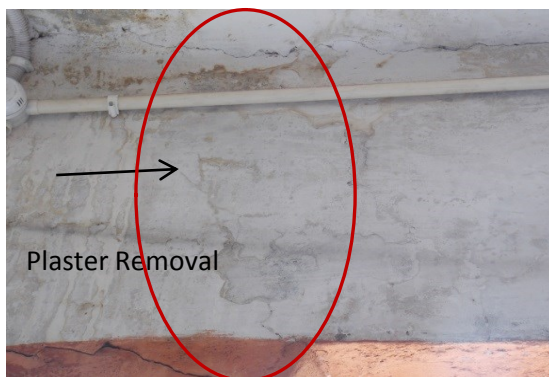
Photo 11

Plaster Removal on Beam of Varandah of Shop No.330,Ground Floor

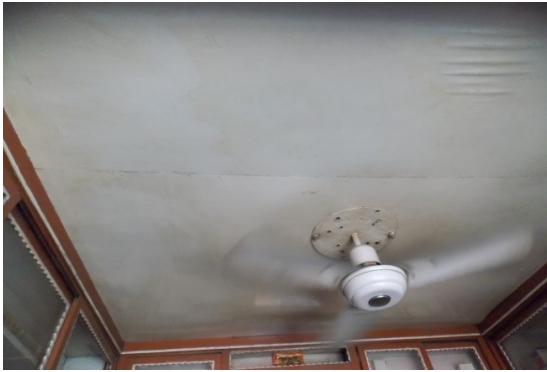
Photo 13

Covered with wooden, All Walls of Shop No. 330, Ground floor
